Pre Building Condition Survey Report

Name and Address of Structure :	Choti Chopar to Badi Chopar (Down Line)
---------------------------------	---

Name of the Project	Contract JMRC-UG1B “Design and Construction of Tunnel between Chandpole and Badi Chouper and reverse line by Shield TBM, Underground Metro Stations at Choti Chouper and Badi Chouper by Cut and Cover Methods on East West Corridor of Jaipur Metro Rail Corporation Limited .”	
Owner :

Pre Building Condition Survey Report Choti Chopar to Badi Chopar (Down Line)

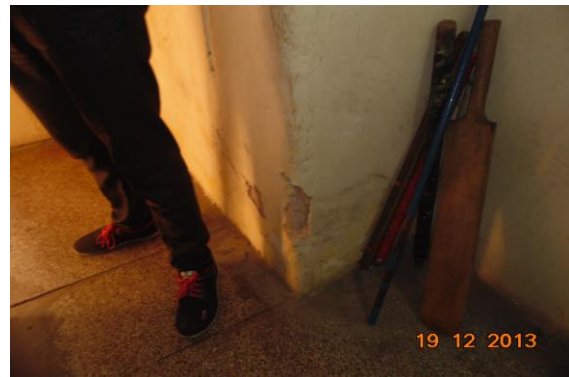
Photo 45
Peeling of Plaster on Wall No. 3 of Lobby of First Floor

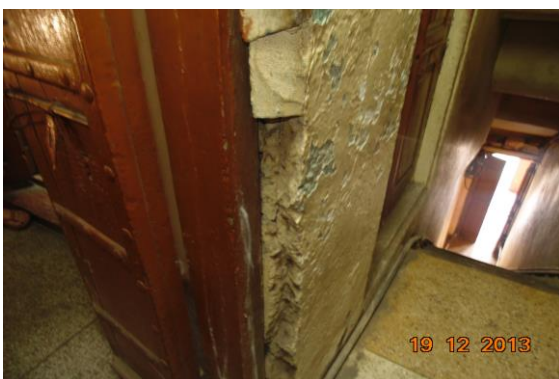
Photo 46
Damaged Portion on Wall No. 2 of Toilet No. 2 of First Floor

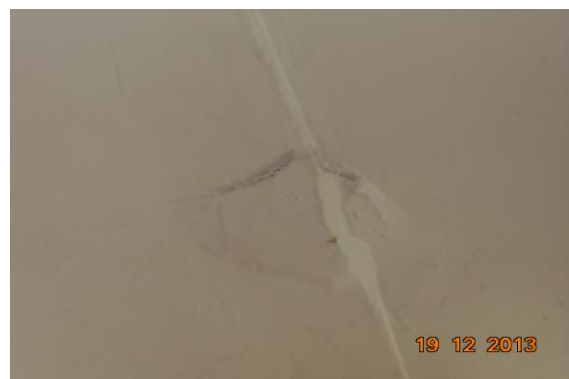
Photo 47
Peeling of Plaster on Roof of Room No. 3 of First Floor

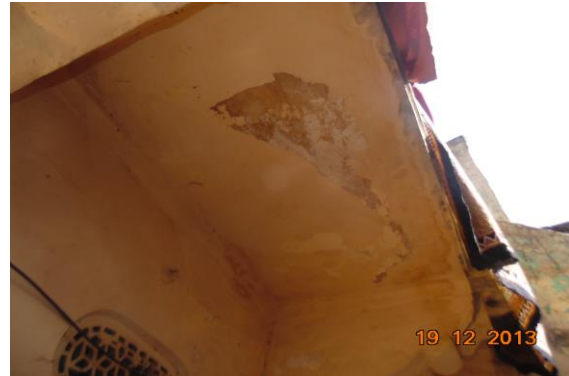
Photo 49
Dampness/Seepage on Wall No. 4 & Sun shade of Open Sky Area of First Floor

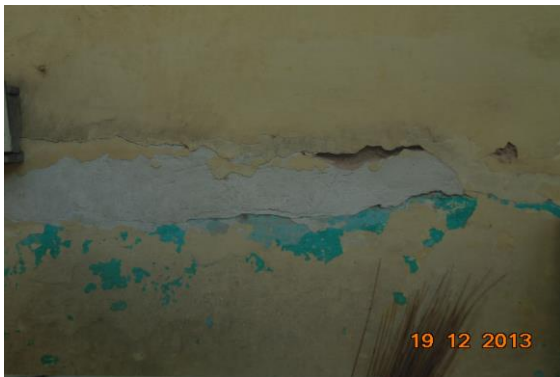
Photo 50
Peeling of Plaster on Wall No. 3 of Open Sky Area of First Floor

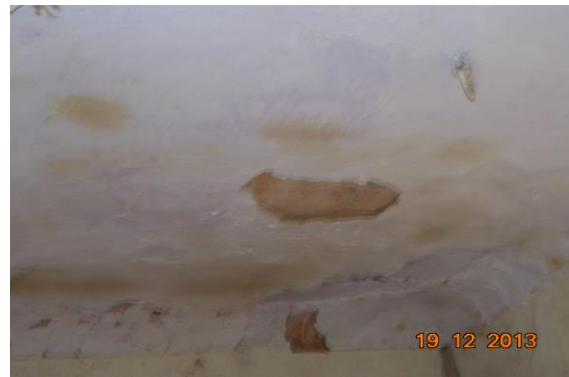
Photo 51
Peeling of Plaster on Roof of Bathroom of First Floor

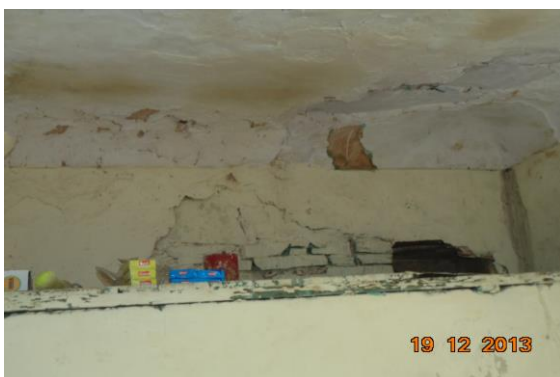
Photo 52
Peeling of Plaster on Wall No. 1 & Roof of Bathroom No. of First Floor

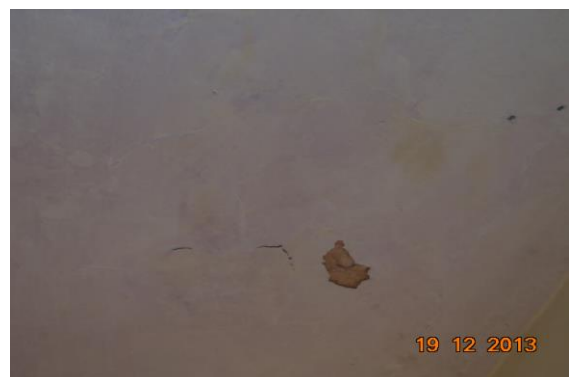
Photo 53
Dampness/Seepage on Roof of Bathroom of First Floor

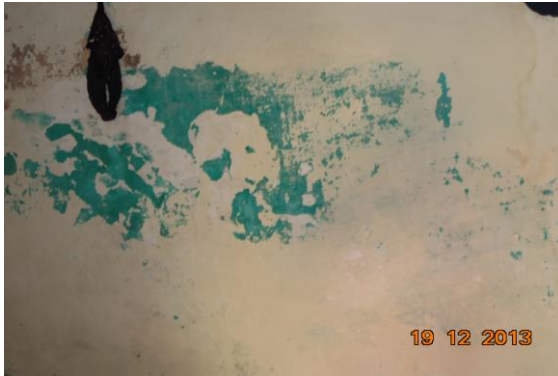
Photo 54
Dampness/Seepage on Wall No. 4 of Bathroom of First Floor

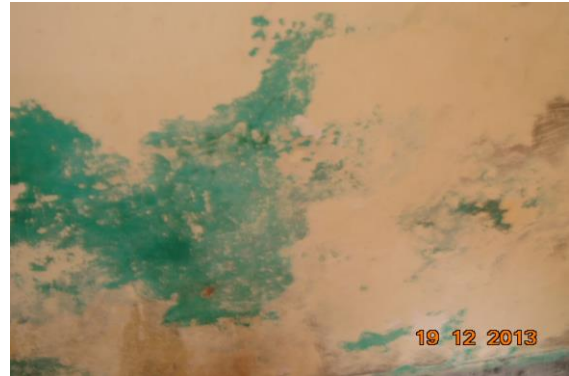
Photo 55
Dampness/Seepage on Wall No. 1 of Bathroom of First Floor

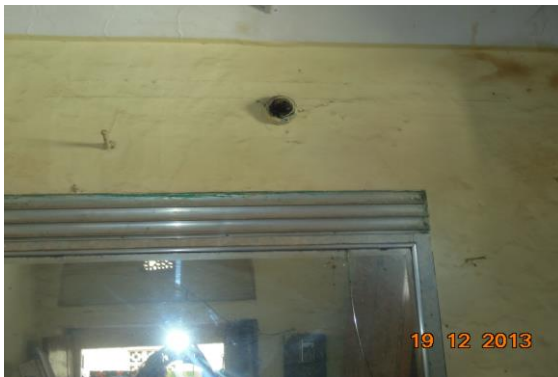
Photo 56
Dampness/Seepage on Wall No. 4 of Store No.3 of First Floor

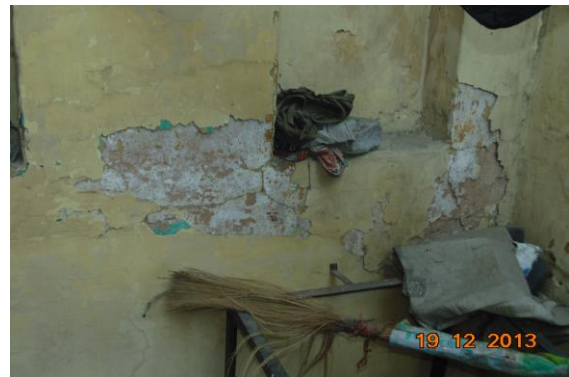
Photo 57
Peeling of Plaster on Wall No. 3 of Open Sky Area of First Floor

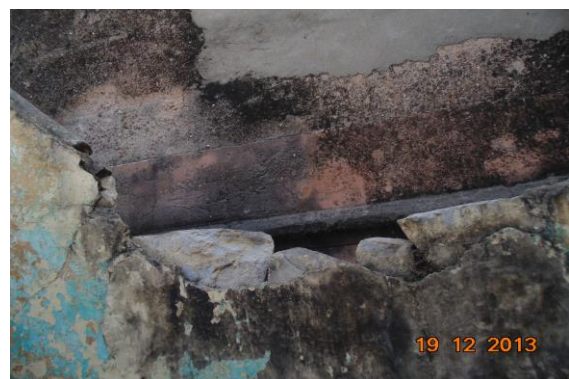
Photo 59
Damaged Portion on Wall No. 2 of Store of First Floor

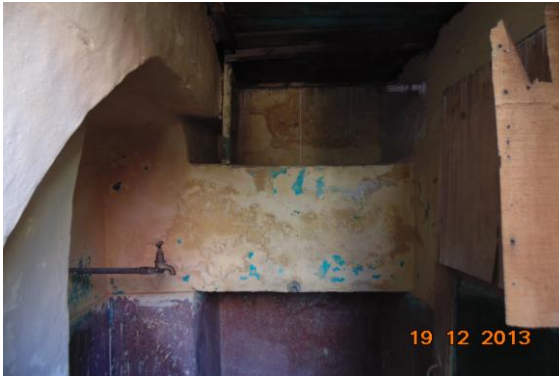
Photo 60
Dampness/Seepage on Wall No. 4 of Water tank Area of First Floor

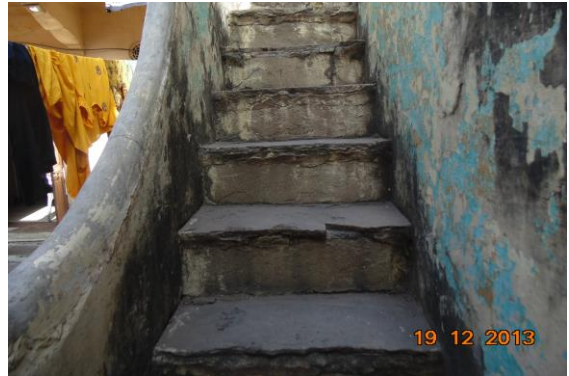
Photo 61
Damaged Portion on Step, 1 & 2 of Staircase Area of First Floor

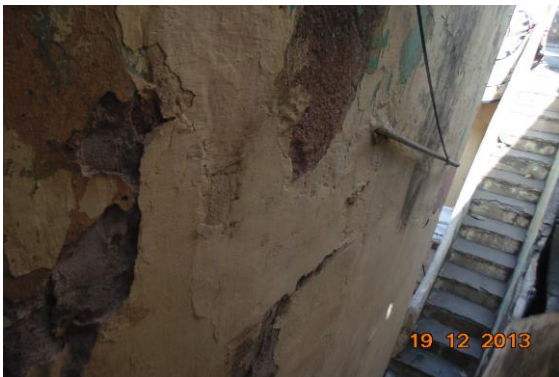
Photo 62
Peeling of Plaster on Wall No. 2 of Staircase First Floor to Second Floor of First Floor

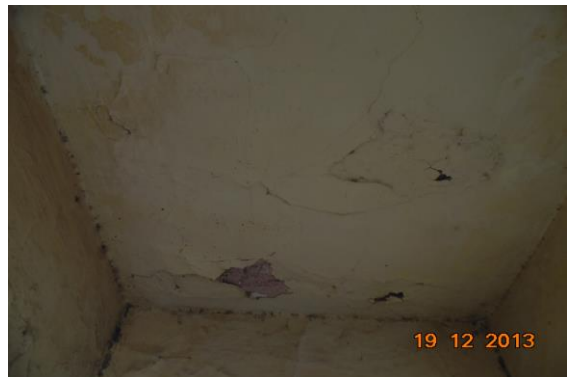
Photo 63
Peeling of Plaster on Roof of Staircase First Floor to Second Floor of First Floor

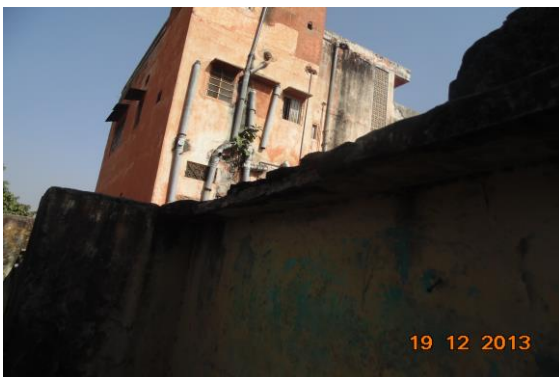
Photo 64
Damaged Portion on Wall No. 3 & Sun Shade of Open Sky area of Second Floor

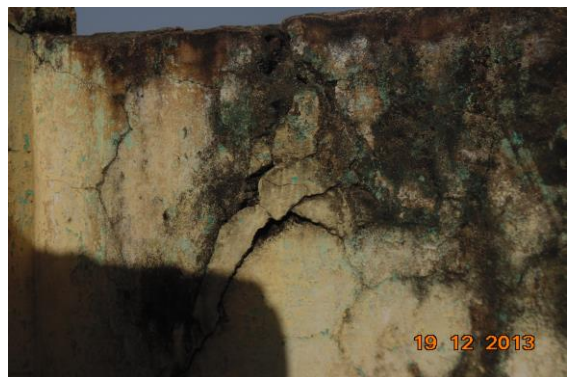
Photo 65
Peeling of Plaster on Wall No. 2 of Open Sky area of Second Floor

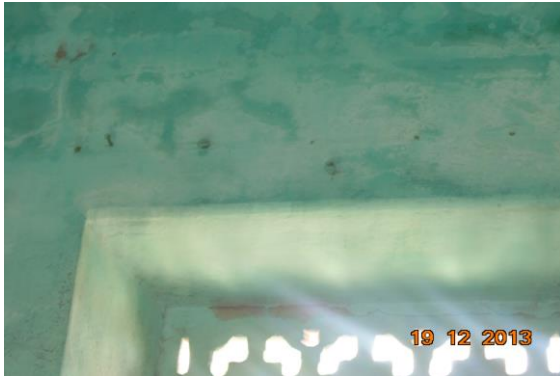
Photo 66

Dampness/Seepage on Wall No. 4 of Room No. 1 of Second Floor

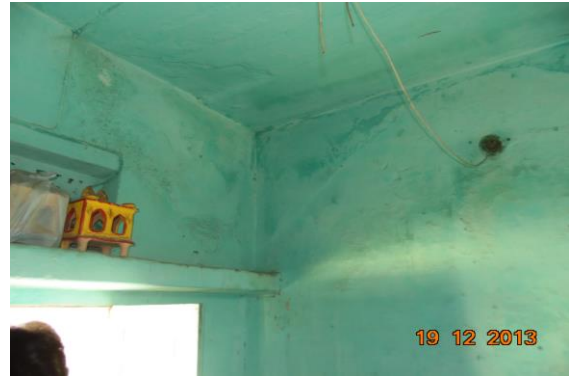
Photo 67

Dampness/Seepage on Wall No. 3 & 1 of Room No. 1 of Second Floor

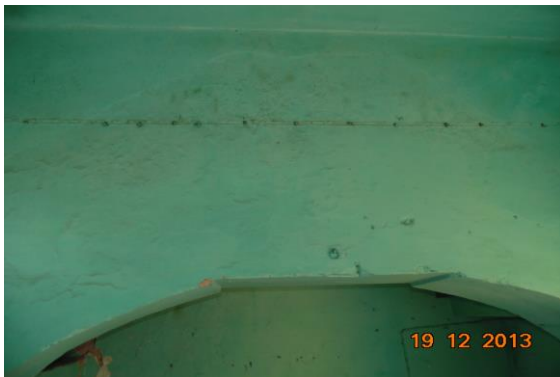
Photo 68

Dampness/Seepage on Wall No. 2 of Room No. 1 of Second Floor

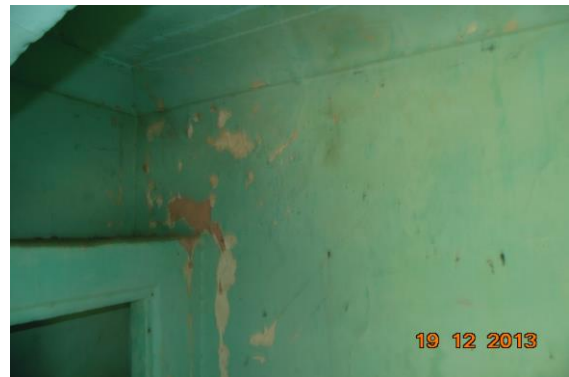
Photo 69

Peeling of Plaster on Wall No. 2 of Room No. 1 of Second Floor

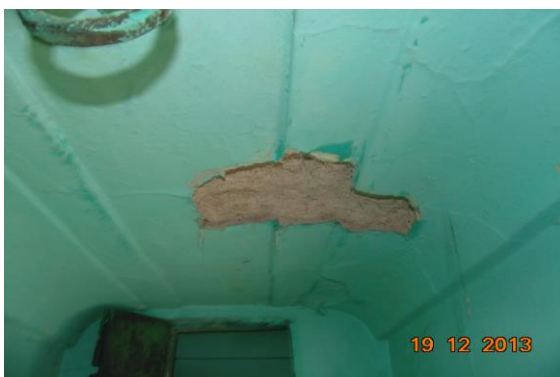
Photo 70

Dampness/Seepage on Roof of Room No. 1 of Second Floor

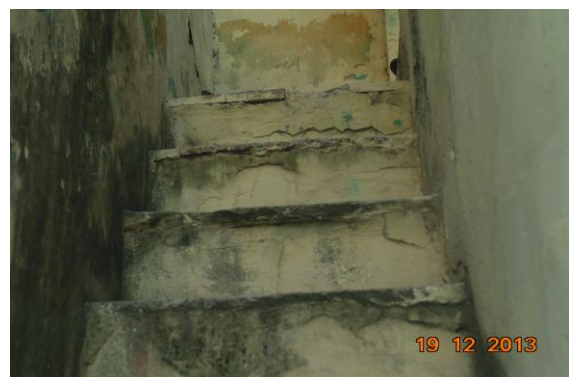
Photo 71

Damaged Portion on Steps of Staircase First Floor to Second Floor of Second Floor

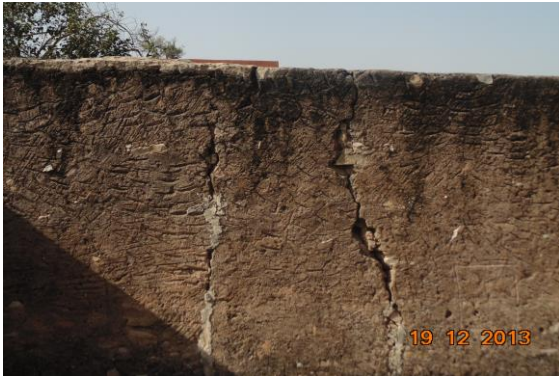
Photo 72

Damaged Portion on Wall No. 1 & Parapet Wall of House No.36 of Terrace

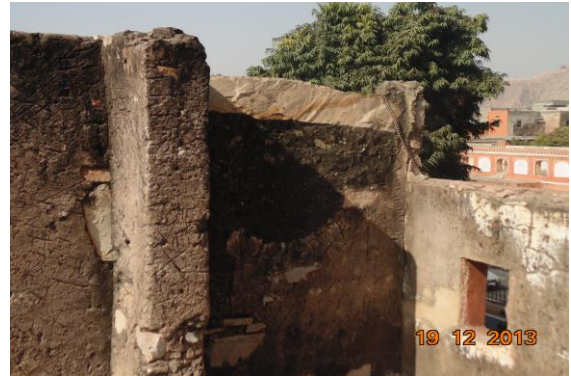
Photo 73

Damaged Portion on Wall No. 1 & Parapet Wall of House No.36 of Terrace

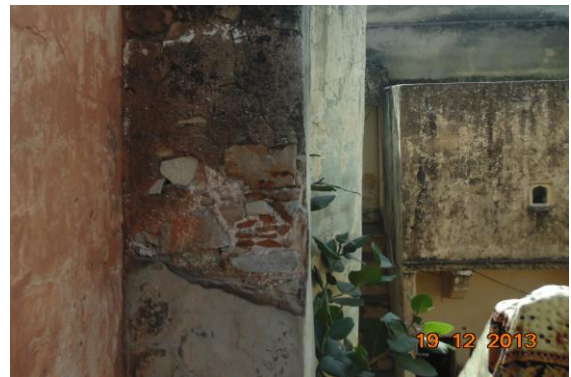
Photo 75

Peeling of Plaster on Wall No. 3 & Parapet Wall of House No.36 of Terrace

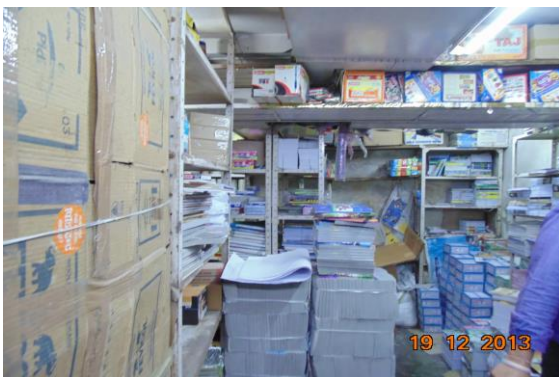
Photo 76

All walls of Shop Suresh & Company of Ground Floor Covered With Material

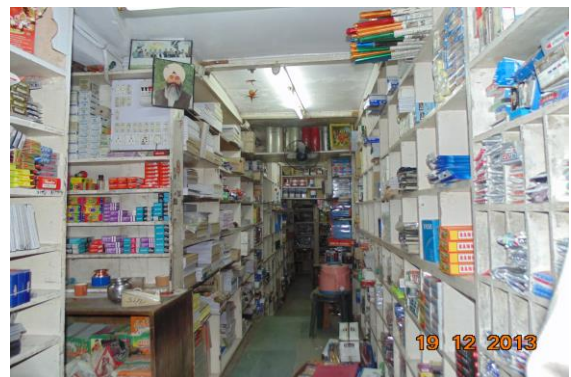
Photo 77

All walls of Shop Kingsons of Ground Floor Covered With Material

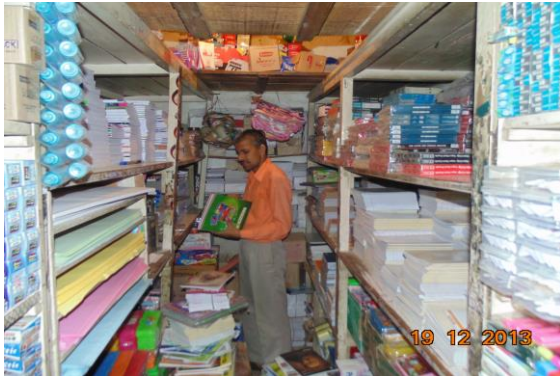
Photo 78

Wall No. 1, 2 & 4 of Part B of Shop Lenco of Ground Floor Covered With Material

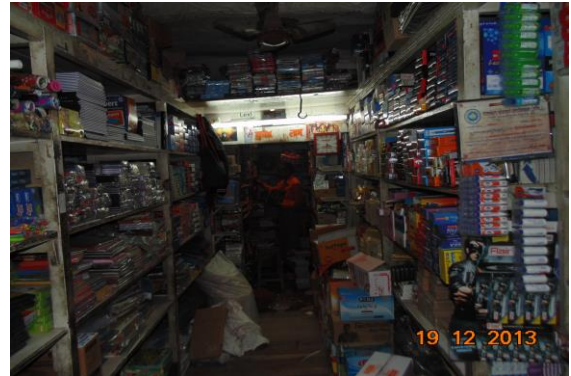
Photo 79

All walls of Part A of Shop Lenco of Ground Floor Covered With Material

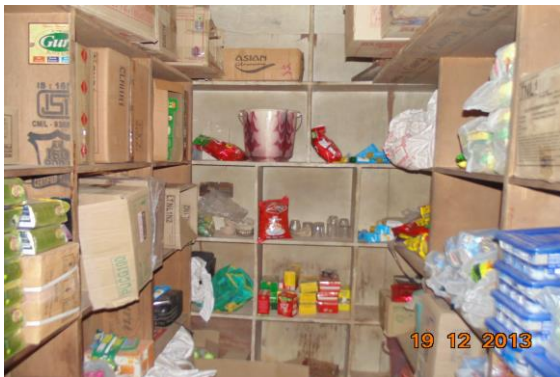
Photo 80

Wall No. 4 of Shop Man Mohan Traders of Ground Floor Covered With Wooden Rack & Material

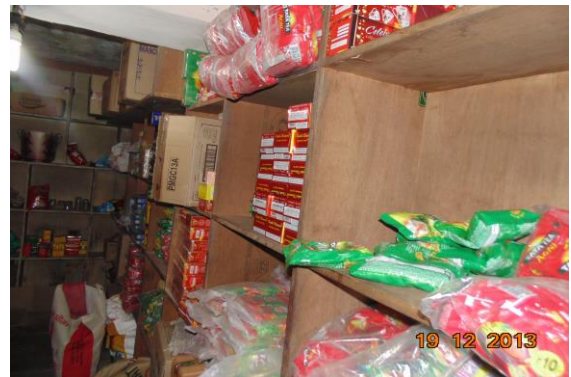
Photo 81

Wall No. 2 of Shop Man Mohan Traders of Ground Floor Covered With Wooden Rack & Material

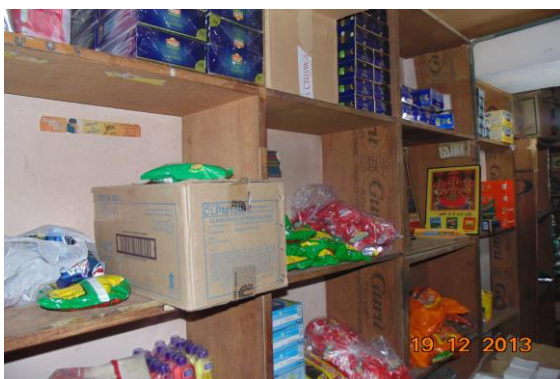
Photo 82

Wall No. 1 of Shop Man Mohan Traders of Ground Floor Covered With Wooden Rack & Material

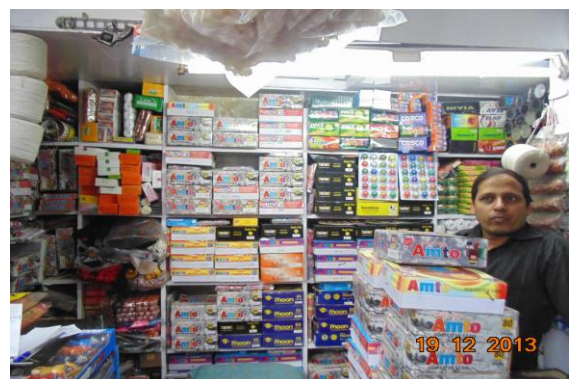
Photo 83

All walls of Shop Mahesh Brothers of Ground Floor Covered With Material

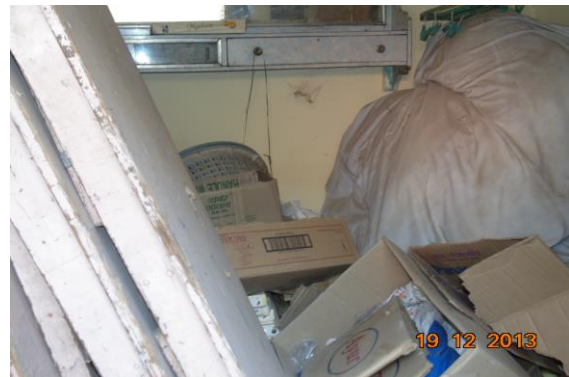
Photo 87
All Walls of Store No.3 of First Floor Covered with Material

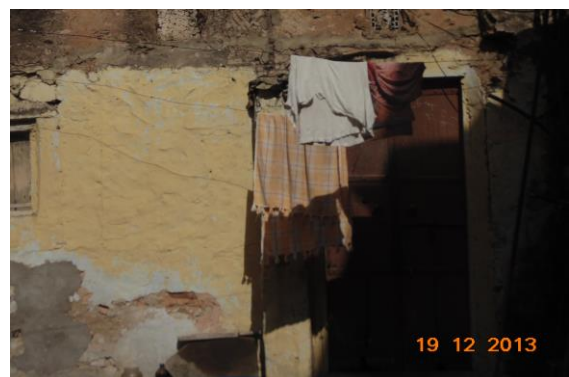
Photo 89
Room No. 4 of First Floor Locked

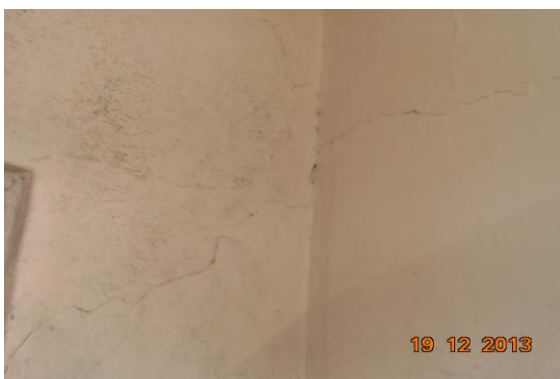
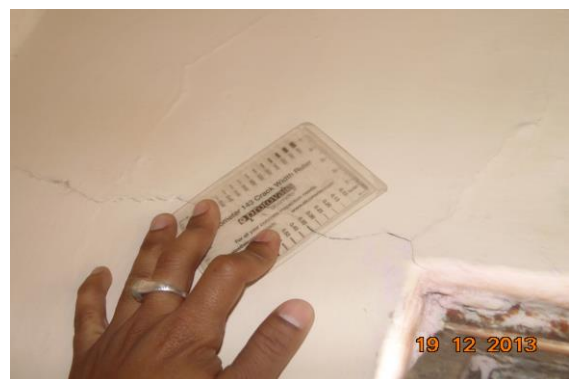
Summary of Cracks						
Defect ID	Location	Orientation	Appx. Width (mm)	Appx. Length (m)	Category	Photo No.
1	Wall No. 2 & 4 Kitchen of House No.38 First Floor	Inclined	0.35	0.8	Very Slight	5, 5A

Photo 5
Inclined Crack on Wall No. 2 & 4 of Kitchen of House No.38, First Floor
Approx. Width = 0.35mm, Approx. Length = 0.8m. Distance from Wall No.2 = 1.2m, Height from Floor = 1.5m.

Photo 5A
Inclined Crack on Wall No. 2 & 4 of Kitchen of House No.38, First Floor
Approx. Width = 0.35mm, Approx. Length = 0.8m. Distance from Wall No.2 = 1.2m, Height from Floor = 1.5m.

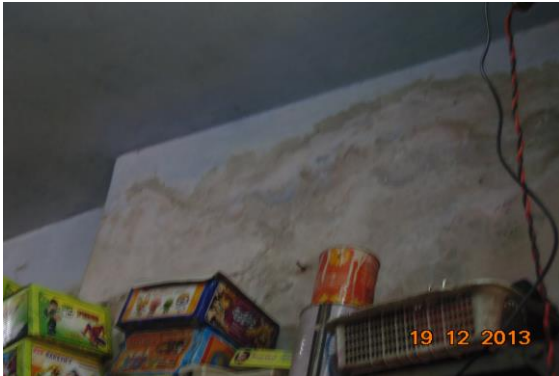
Photo 6

Dampness/Seepage on Wall No. 2 of Part A Shop Dinesh Treaders of Ground Floor

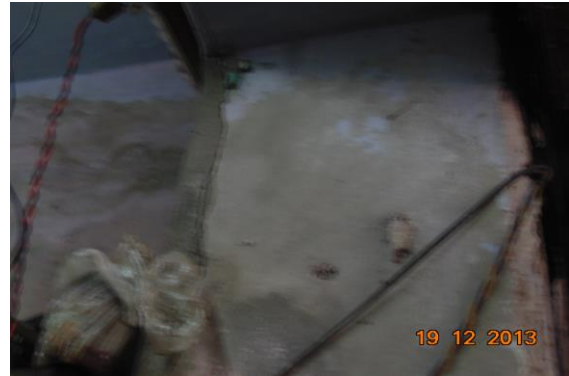
Photo 7

Peeling of Plaster on Wall No. 2 of Part A Shop Dinesh Treaders of Ground Floor

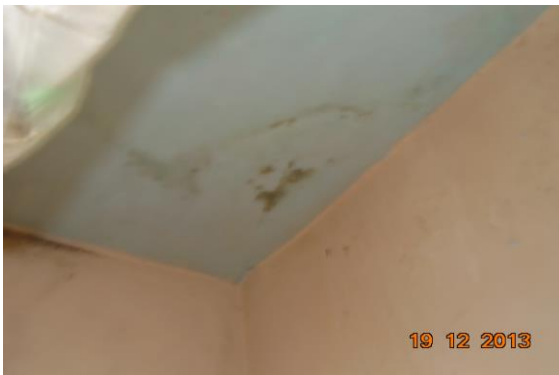
Photo 8

Dampness/Seepage on Roof of Kitchen of House No.38 of First Floor

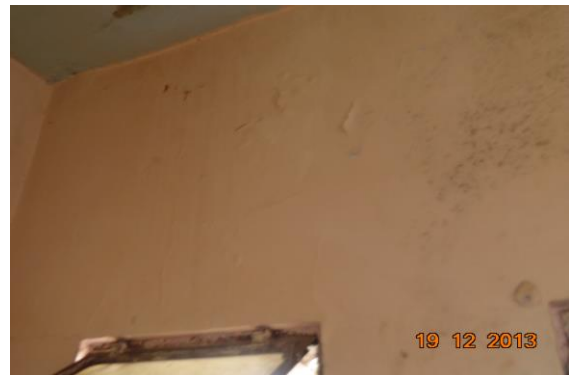
Photo 9

Peeling of Plaster on Wall No. 4 of Kitchen of House No.38 of First Floor

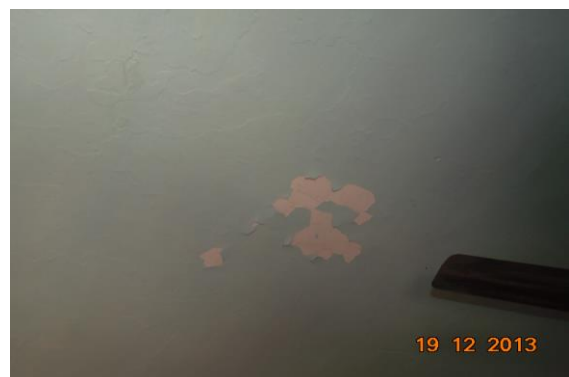
Photo 11

Peeling of Plaster on Roof of Room No. 1 of House No.38, First Floor

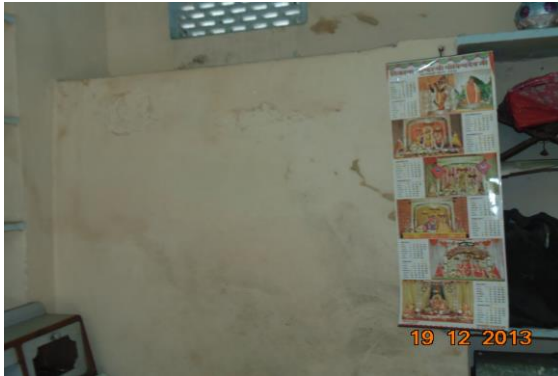
Photo 12

Dampness/Seepage on Wall No. 2 of Room No. 1 of House No.38, First Floor

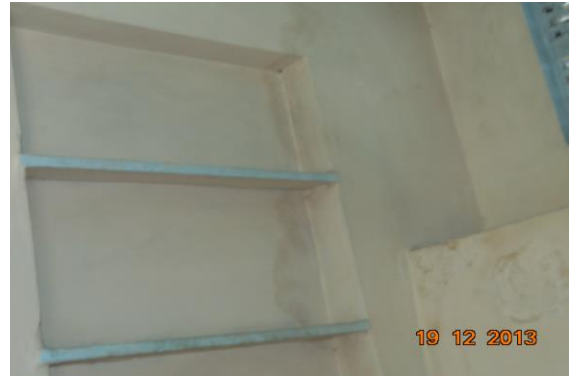
Photo 13

Dampness/Seepage on Wall No. 4 of Room No. 1 of House No.38, First Floor

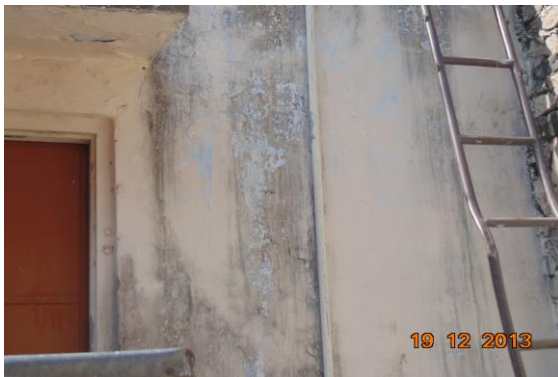
Photo 14

Dampness/Seepage on Outer Wall No.3 of House No.38 of First Floor

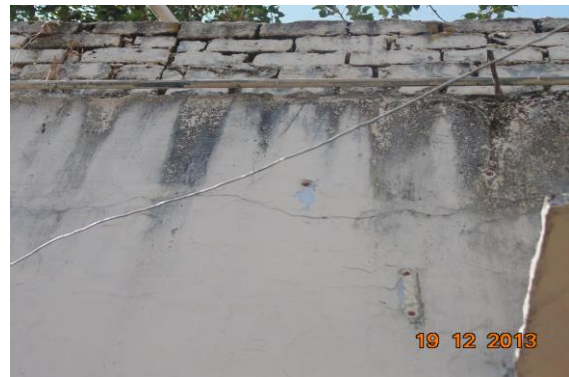
Photo 15

Peeling of Plaster on Outer Wall No.3 of House No.38 of First Floor

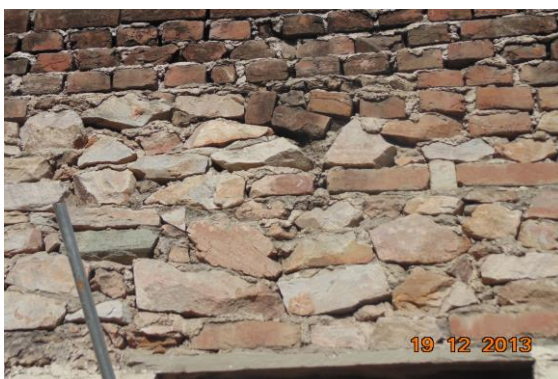
Photo 16

Peeling of Plaster on Wall No. 2 of Open Sky of First Floor

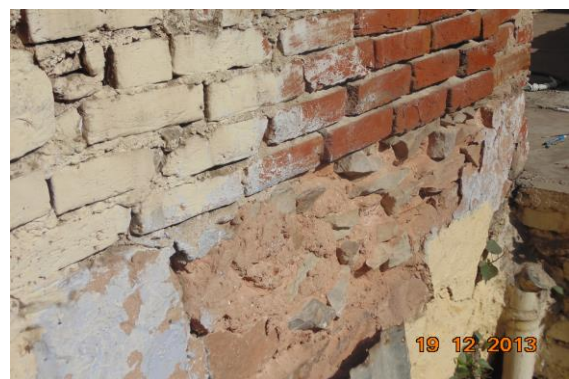
Photo 17

Peeling of Plaster on Wall No. 2 of Open Sky of First Floor

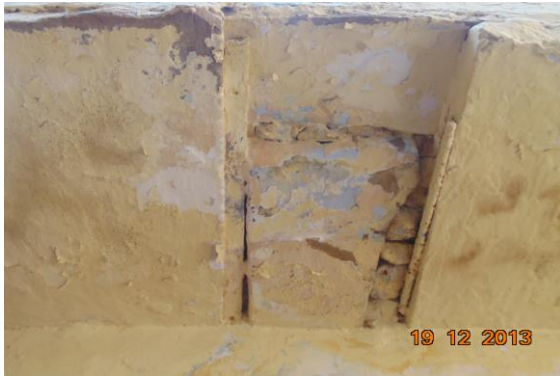
Photo 18

Peeling of Plaster on Roof of House No.38 of Ground Floor

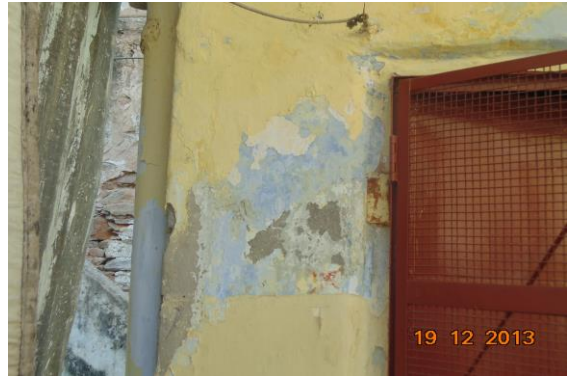
Photo 19

Peeling of Plaster on Outer Wall No.3 of House No.38 of Ground Floor

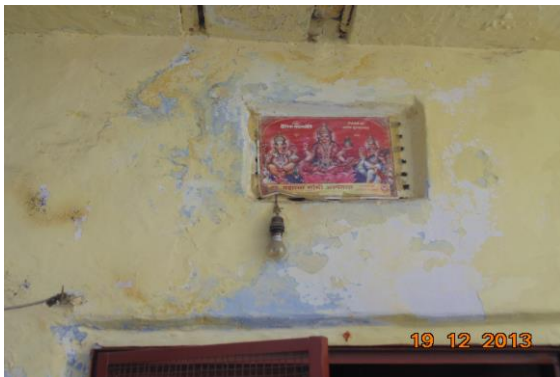
Photo 20

Dampness/Seepage on Outer Wall No.3 of House No.38 of Ground Floor

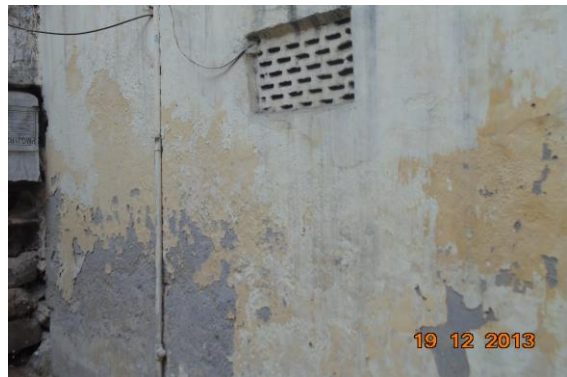
Photo 21

Dampness/Seepage on Leftside Wall of House No.38 of Ground Floor

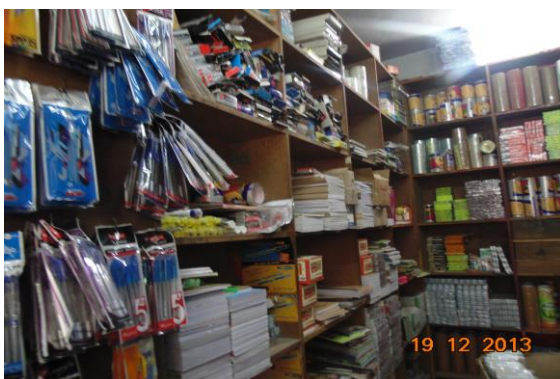
Photo 22

Wall No. 4 of Part A Shop Dinesh Treaders of Ground Floor Covered With Material

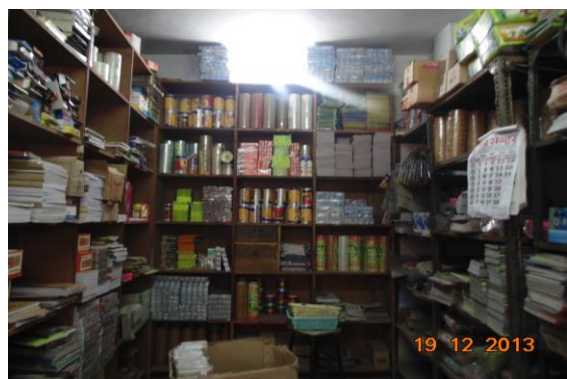
Photo 23

Wall No. 1 of Part A Shop Dinesh Treaders of Ground Floor Covered With Material

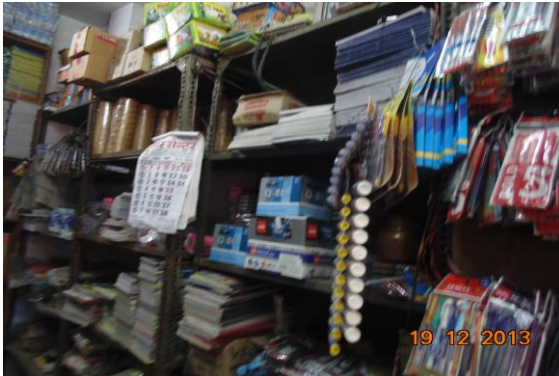
Photo 24

Wall No. 2 of Part A Shop Dinesh Treaders of Ground Floor Covered With Material

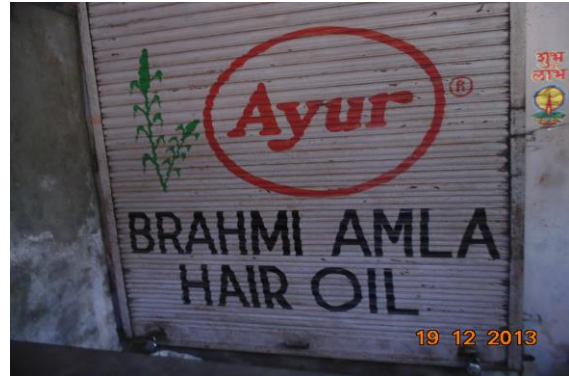
Photo 25

Part B Shop Dinesh Treaders of Ground Floor Locked

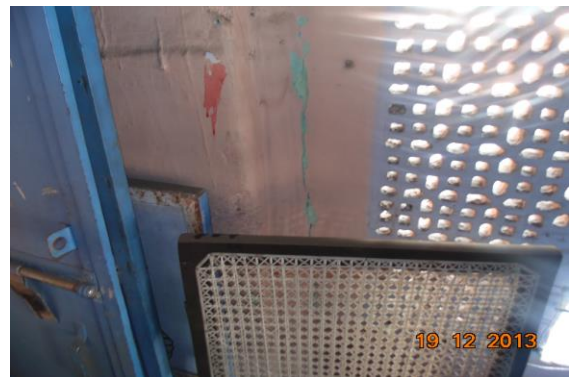
Photo 22
Inclined Crack on Wall No. 1 of Room No. 3, Parshu Ram Public School, First Floor, Approx. Width = 1mm, Approx. Length = 1m. Distance from Wall No.3 = 0.4m, Height from Floor = 0.5m.

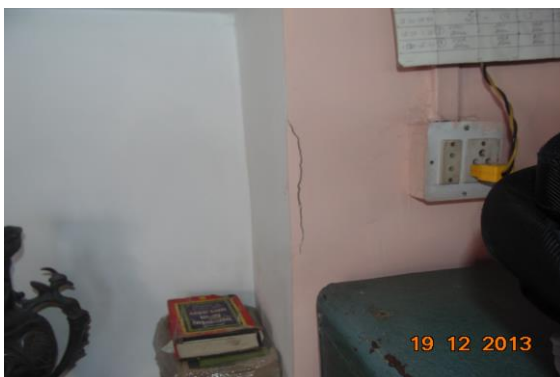
Photo 23
Inclined Crack on Wall No. 1 of Office, First Floor
Approx. Width = 1.5mm, Approx. Length = 0.2m.
Distance from Wall No.4 = 0.4m, Height from Floor = 1.1m.

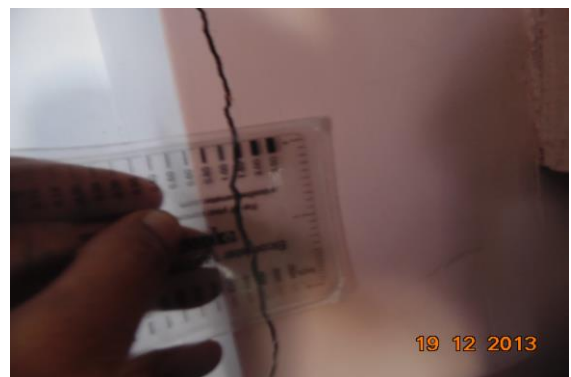
Photo 24
Inclined Crack on Wall No. 1 of Office, First Floor
Approx. Width = 1.5mm, Approx. Length = 0.2m.
Distance from Wall No.4 = 0.4m, Height from Floor = 1.1m.

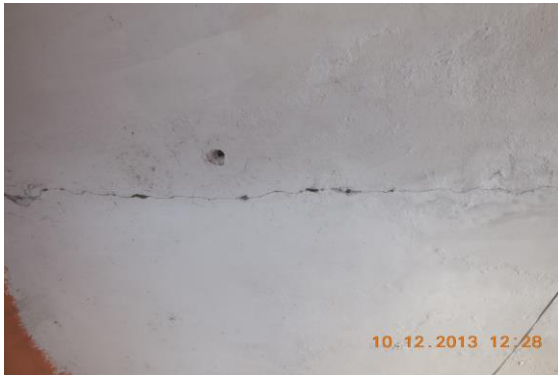
Photo 25

Horizontal Crack on Roof of Varanda of Shop No.364A, Ground Floor, Approx. Width = 1mm, Approx. Length = 2m. Distance from Left External Column = 0m, Height from Floor = 3m.

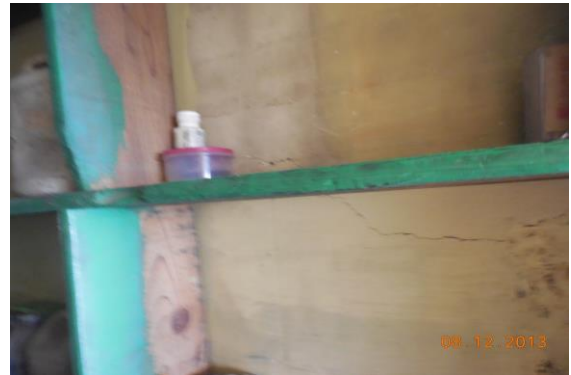
Photo 26

Inclined Crack on Wall No. 2 of Shop No.364 B, Ground Floor Approx. Width = 1mm, Approx. Length = 4.15m. Distance from Main Door = 3.5m, Height from Floor = 1.7m.

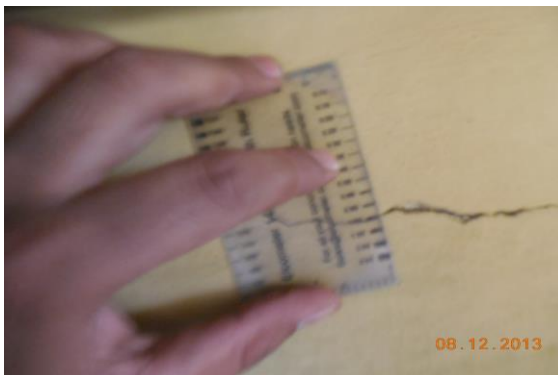
Photo 27

Inclined Crack on Wall No. 2 of Shop No.364 B, Ground Floor Approx. Width = 1mm, Approx. Length = 4.15m. Distance from Main Door = 3.5m, Height from Floor = 1.7m.

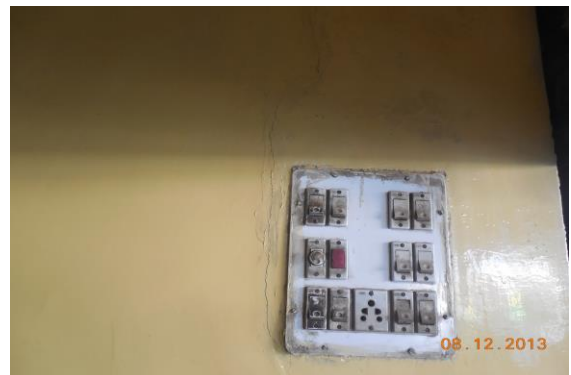
Photo 28

Inclined Crack on Wall No. 2 of Shop No.364 B, Ground Floor Approx. Width = 0.5mm, Approx. Length = 1.05m. Distance from Main Door = 0.32m, Height from Floor = 1.3m.

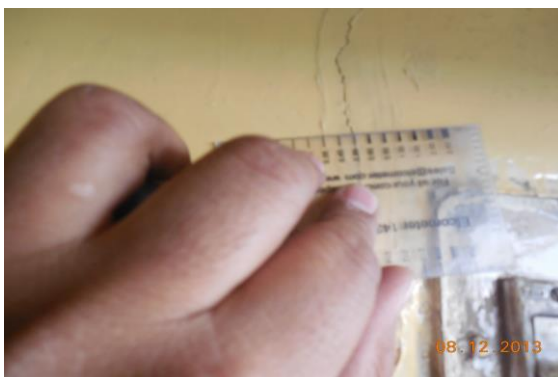
Photo 28A

Inclined Crack on Wall No. 2 of Shop No.364 B, Ground Floor Approx. Width = 0.5mm, Approx. Length = 1.05m. Distance from Main Door = 0.32m, Height from Floor = 1.3m.

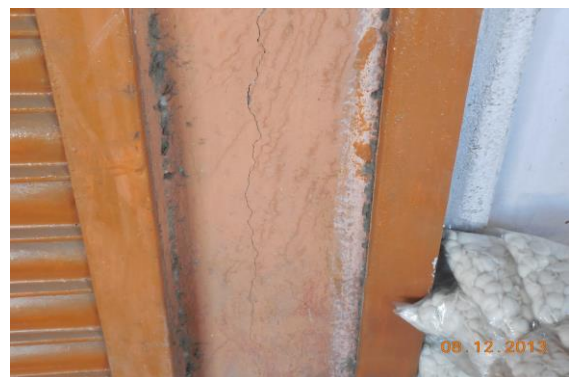
Photo 29

Inclined Crack on Leftside External Column of Varanda of Shop No.365, Ground Floor, Approx. Width = 0.6mm, Approx. Length = 1.2m. Distance from Left External Column = 0m, Height Floor = 0m.

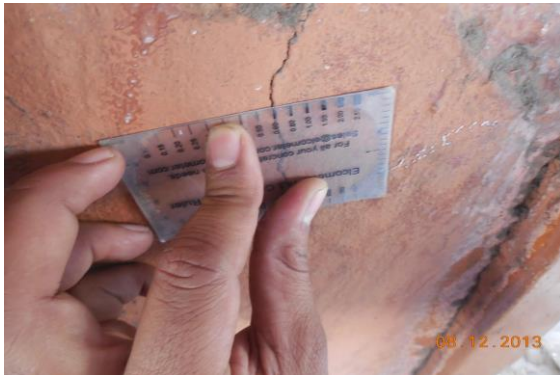
Photo 29A

Inclined Crack on Leftside External Column of Varanda of Shop No.365, Ground Floor, Approx. Width = 0.6mm, Approx. Length = 1.2m. Distance from Left External Column = 0m, Height Floor = 0m.

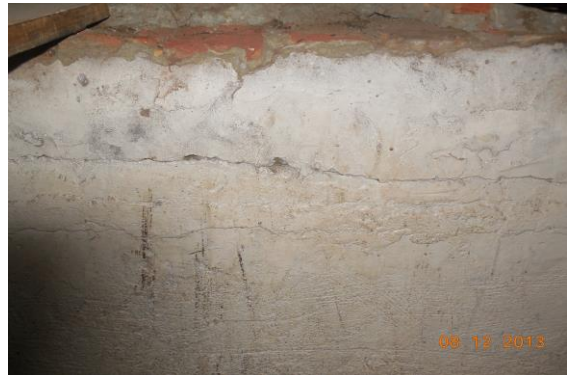
Photo 30

Horizontal Crack on Staircase Area, Basement
Approx. Width = 1mm, Approx. Length = 3m.
Distance from Wall No.2 = 0m, Height from Floor = 1.1m.

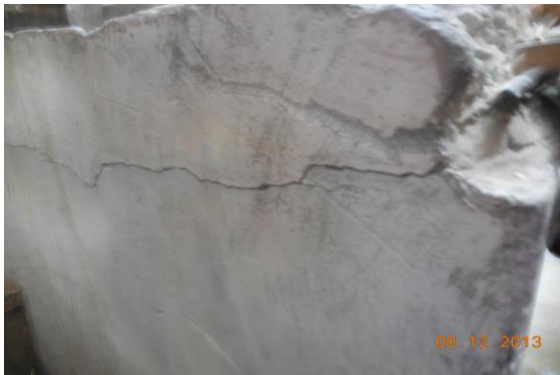
Photo 31

Inclined Crack on Wall No. 1 of Staircase Area, Basement
Approx. Width = 1.5mm, Approx. Length = 1m.
Distance from Wall No.3 = 0m, Height from Floor = 0.3m.

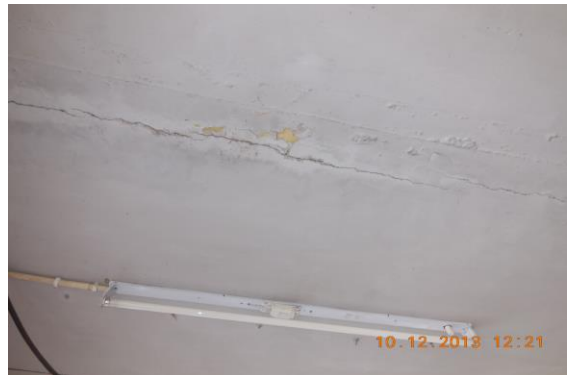
Photo 32

Horizontal Crack on Roof of Varanda, Shop no.367, Ground Floor
Approx. Width = 1mm, Approx. Length = 2m.
Distance from Left External Column = 0m, Height from Floor = 3m.

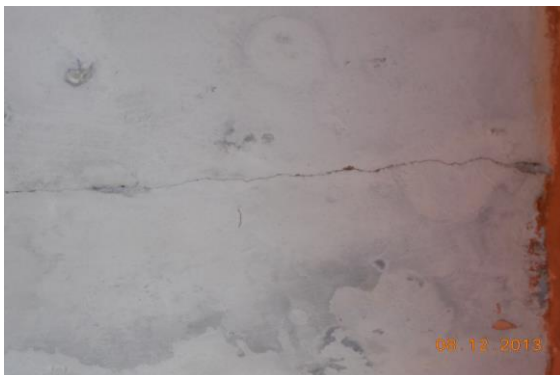
Photo 33

Horizontal Crack on Roof of Varanda, Shop No.368, Ground Floor
Approx. Width = 0.5mm, Approx. Length = 2m.
Distance from Right External Column = 0m, Height from Floor = 3m.

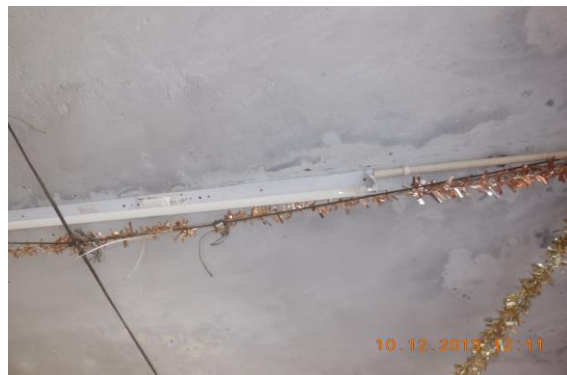
Photo 34

Horizontal Crack on of Varanda, Shop No.369, Ground Floor
Approx. Width = 0.4mm, Approx. Length = 2m.
Distance from Right External Column = 0m, Height from Floor = 3m.

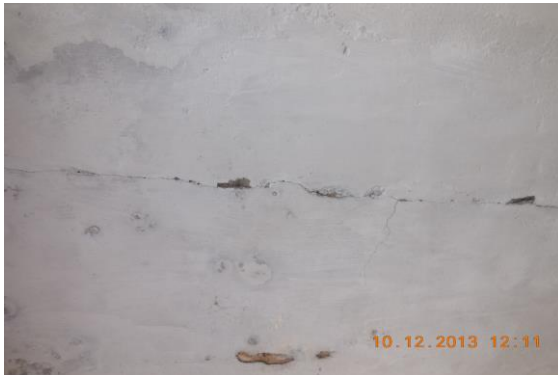
Photo 35

Horizontal Crack on Varanda, Shop No.369, Ground Floor
Approx. Width = 0.8mm, Approx. Length = 2m.
Distance from Left External Column = 0m, Height from Floor = 3m.

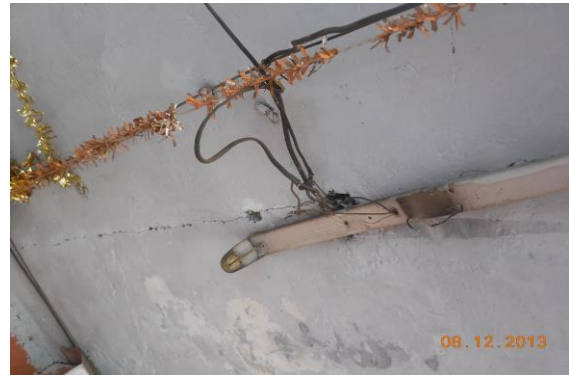
Photo 36

Horizontal Crack on Roof of Varanda, Shop No.370, Ground Floor
Approx. Width = 0.8mm, Approx. Length = 3m.
Distance from Right External Column = 0m, Height from Floor = 3m.

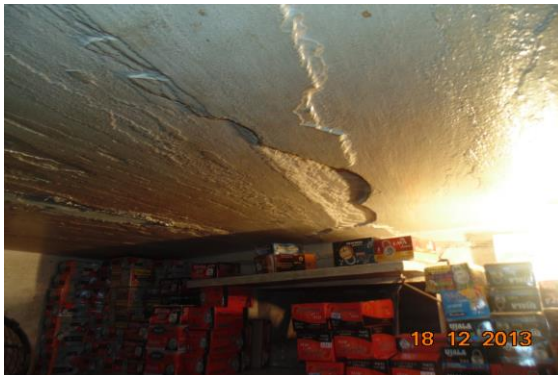
Photo 37

Peeling of Plaster on Roof of Shop Ashok Traders of Ground Floor

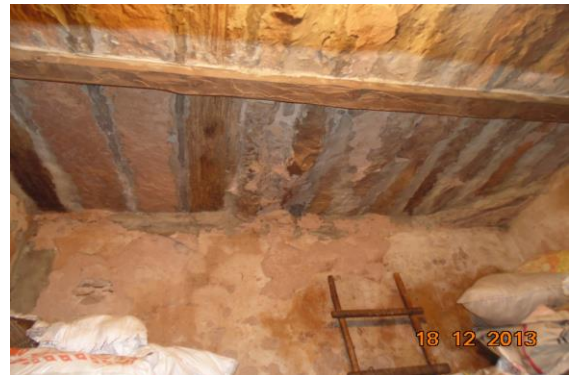
Photo 38

Peeling of Plaster on Wall No.4 & Roof of Part E of Shop G.R.Company of Ground Floor

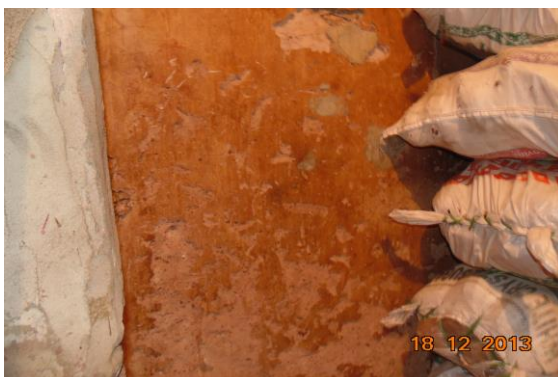
Photo 39

Peeling of Plaster on Wall No. 1 of Part E of Shop G.R.Company of Ground Floor

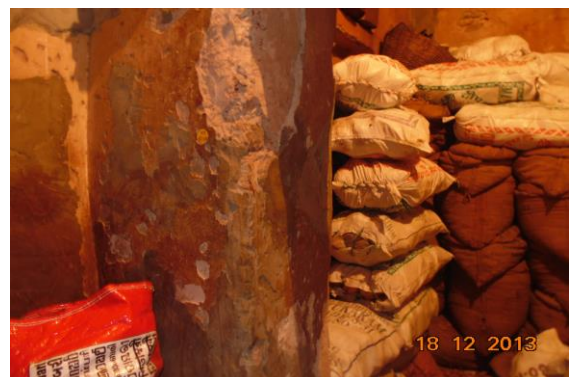
Photo 40

Peeling of Plaster on Leftside & Entry Gate of Part E of Shop G.R.Company of Ground Floor

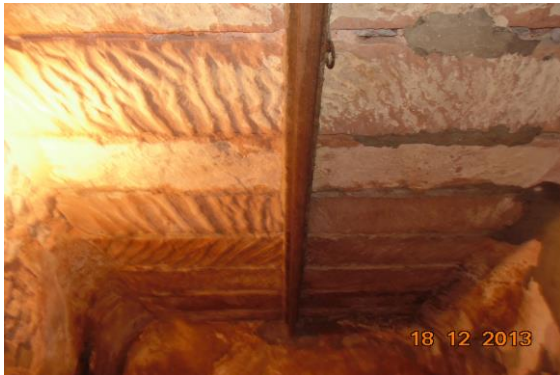
Photo 41

Peeling of Plaster on Roof of Part E of Shop G.R.Company of Ground Floor

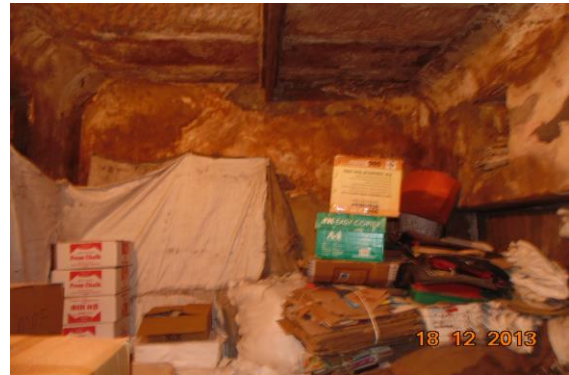
Photo 42

Dampness/Seepage on Wall No. 4 of Part E of Shop G.R.Company of Ground Floor

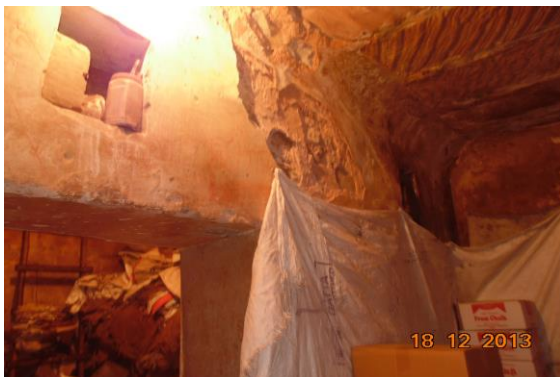
Photo 43

Peeling of Plaster on Part E of Shop G.R.Company of Ground Floor

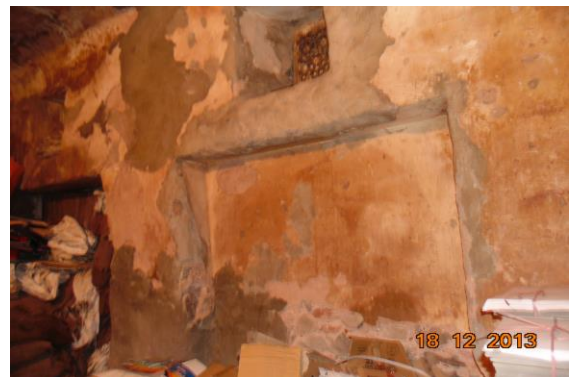
Photo 44

Peeling of Plaster on Wall No. 2 of Part E of Shop G.R.Company of Ground Floor

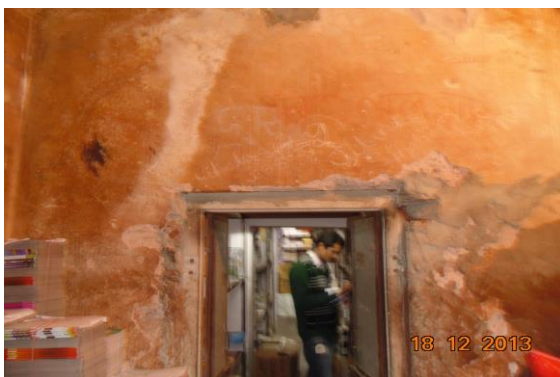
Photo 45

Peeling of Plaster on Wall No. 3 of Part E of Shop G.R.Company of Ground Floor

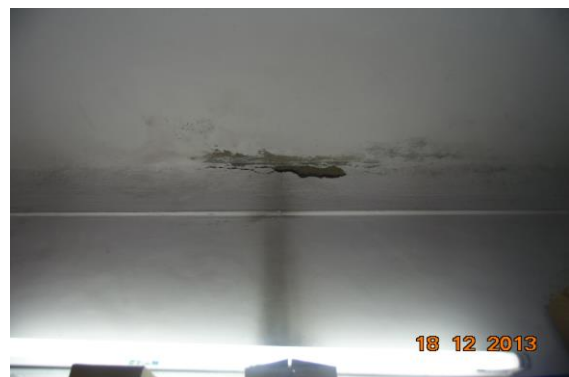
Photo 46

Dampness/Seepage on Roof of Part D of Shop G.R.Company of Ground Floor

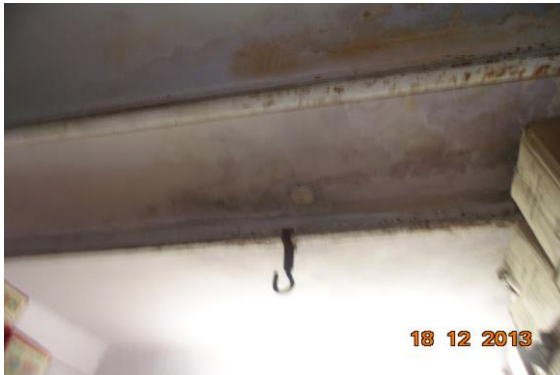
Photo 47

Dampness/Seepage on Roof of Part C of Shop G.R.Company of Ground Floor

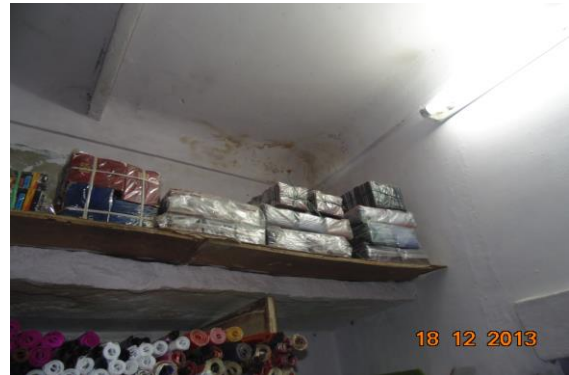
Photo 48

Dampness/Seepage on Wall No. 2, Roof & 3 of Part B of Shop G.R.Company of Ground Floor

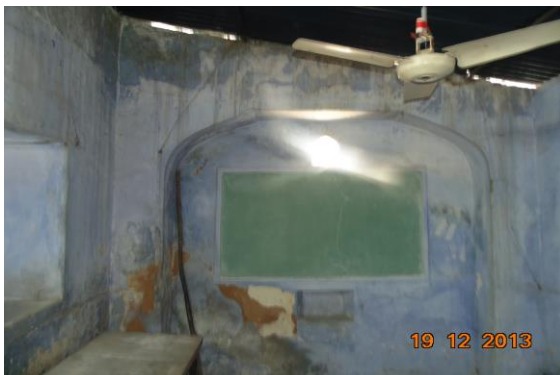
Photo 49

Dampness/Seepage on Wall No. 1 of Room No. 1 of Parshu Ram Public School, First Floor

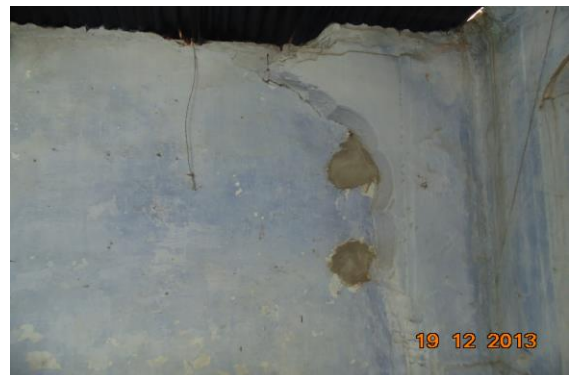
Photo 50

Peeling of Plaster on Wall No. 4 of Room No. 1 of Parshu Ram Public School, First Floor

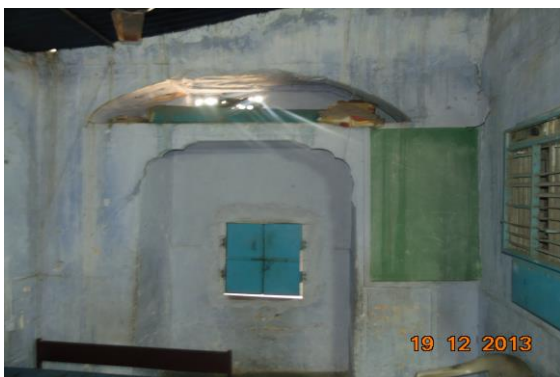
Photo 51

Dampness/Seepage on Wall No. 2 of Room No. 1 of Parshu Ram Public School, First Floor

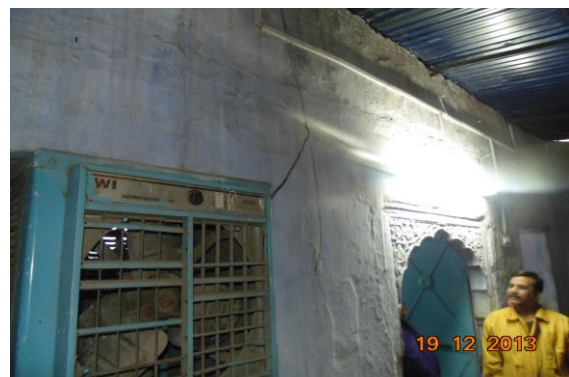
Photo 52

Dampness/Seepage on Wall No. 3 of Room No. 1 of Parshu Ram Public School, First Floor

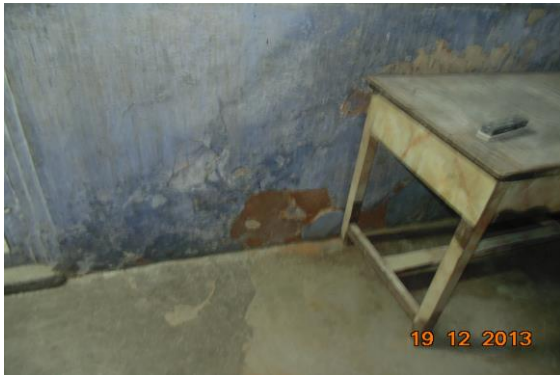
Photo 53

Dampness/Seepage on Wall No. 3 of Room No. 1 of Parshu Ram Public School, First Floor

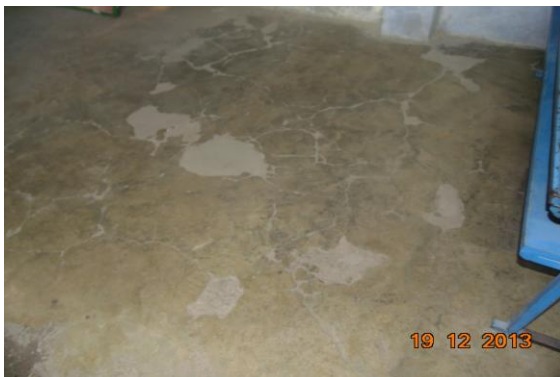
Photo 55

Peeling of Plaster on Floor of Room No. 1 of Parshu Ram Public School, First Floor

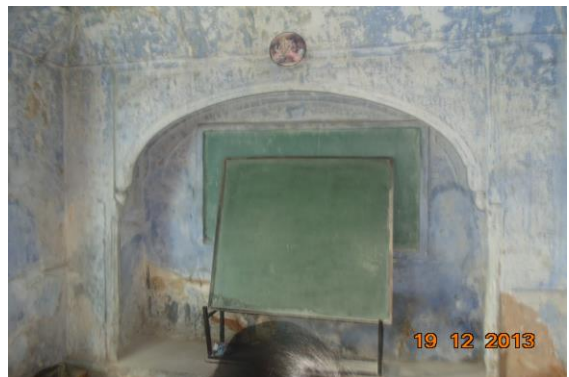
Photo 56

Dampness/Seepage on Wall No. 1 of Room No. 2 of Parshu Ram Public School, First Floor
