Pre Building Condition Survey Report

Name and Address of Structure :	Choti Chopar to Badi Chopar (Down Line)
---------------------------------	---

Name of the Project	Contract JMRC-UG1B “Design and Construction of Tunnel between Chandpole and Badi Chouper and reverse line by Shield TBM, Underground Metro Stations at Choti Chouper and Badi Chouper by Cut and Cover Methods on East West Corridor of Jaipur Metro Rail Corporation Limited .”	
Owner :

Pre Building Condition Survey Report Choti Chopar to Badi Chopar (Down Line)

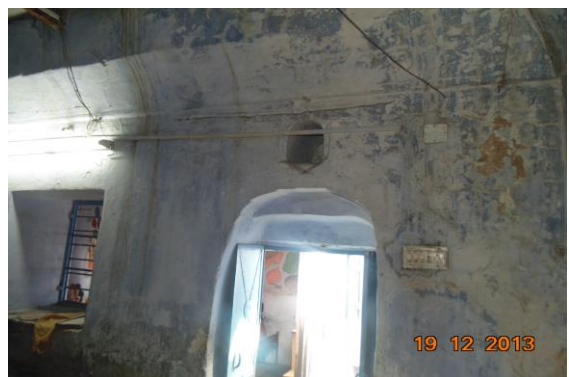
Photo 58

Dampness/Seepage on Wall No. 3 of Room No. 2 of Parshu Ram Public School, First Floor

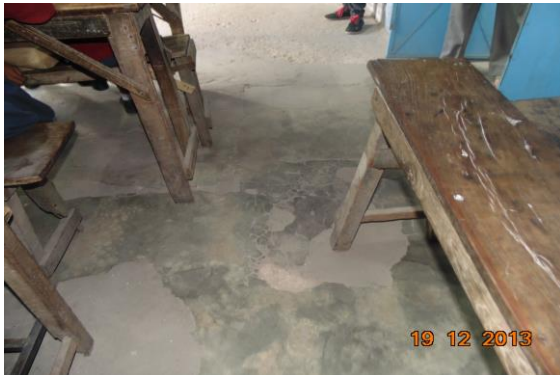
Photo 59

Peeling of Plaster on Floor of Room No. 2 of Parshu Ram Public School, First Floor

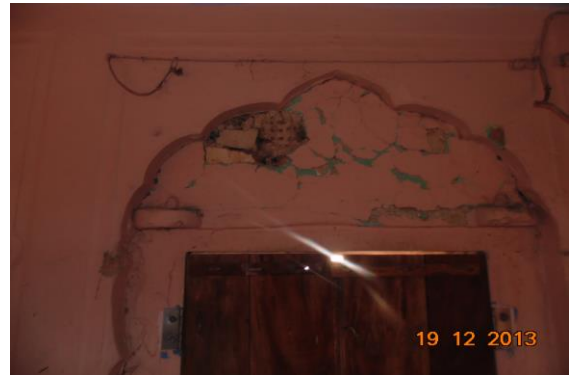
Photo 60

Damaged Portion on Wall No. 4 of Room No. 3 of Parshu Ram Public School, First Floor

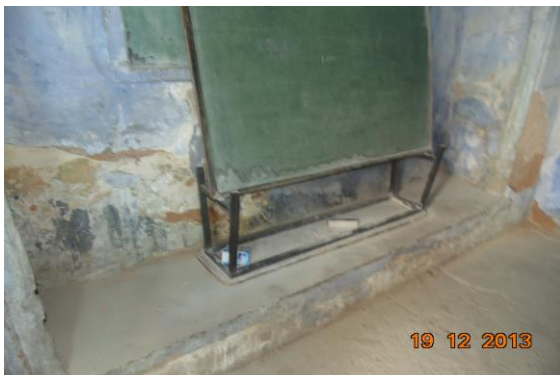
Photo 61

Peeling of Plaster on Wall No. 1 of Room No. 3 of Parshu Ram Public School, First Floor

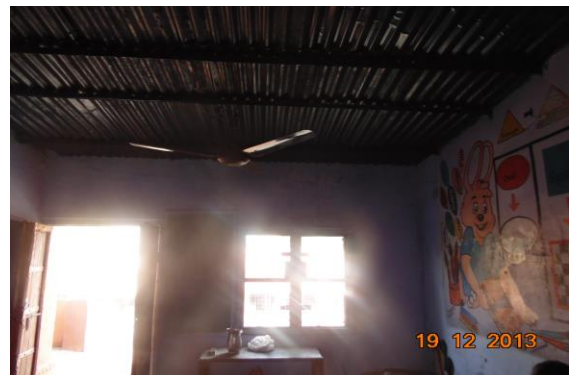
Photo 62

Dampness/Seepage on Wall No. 4 of Room No. 4 of Parshu Ram Public School, First Floor

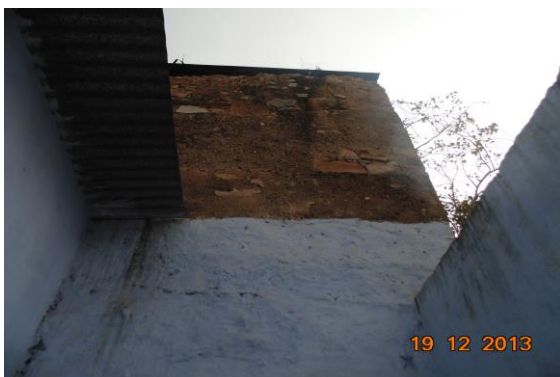
Photo 63

Peeling of Plaster on Wall No. 2 of Open Sky Area of First Floor

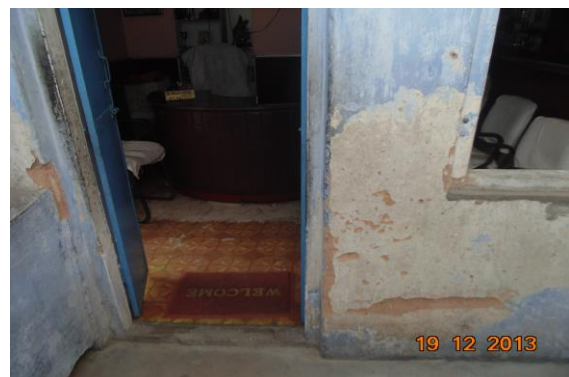
Photo 64

Peeling of Plaster on Wall No. 3 of Open Sky Area of First Floor

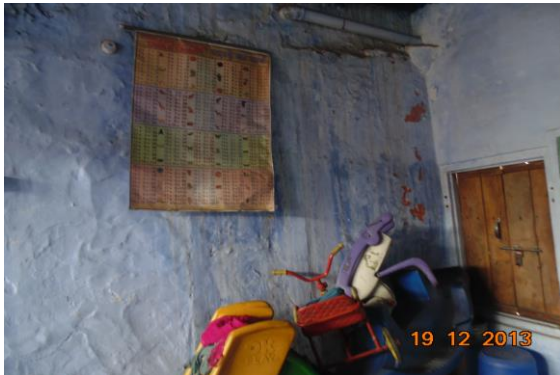
Photo 65

Dampness/Seepage on Wall No. 1 of Hall No. 1 of Parshu Ram Public School, First Floor

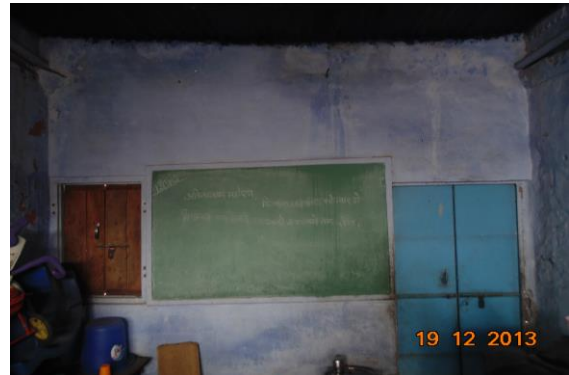
Photo 66

Dampness/Seepage on Wall No. 4 of Parshu Ram Public School of First Floor

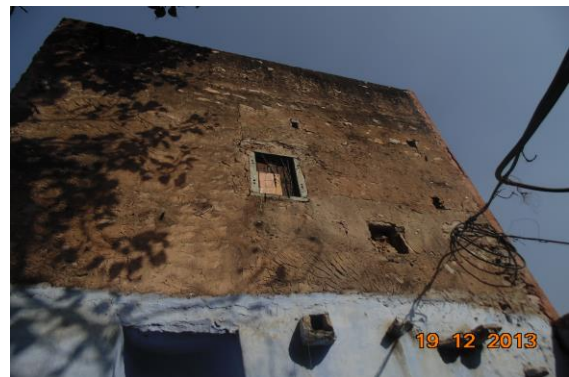
Photo 68

Peeling of Plaster on Wall No. 1 of Open Sky Area No.2 of First Floor

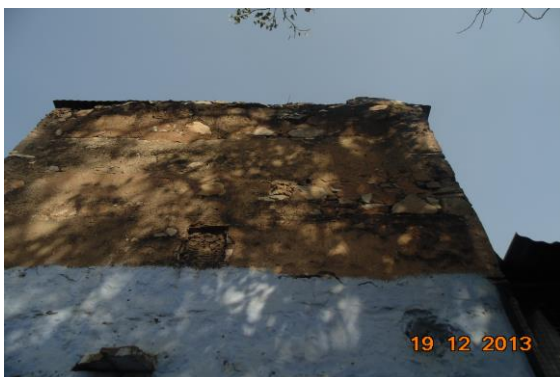
Photo 69

Peeling of Plaster on Wall No. 1 of Open Sky Area No.2 of First Floor

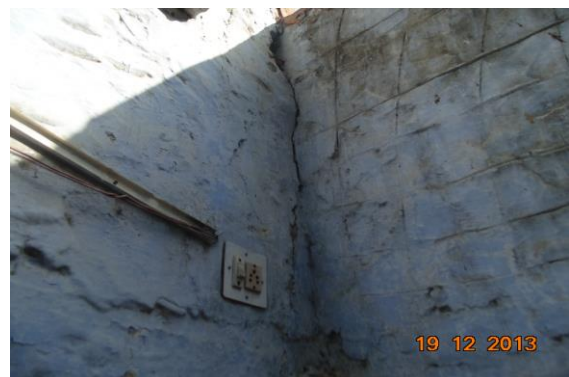
Photo 70

Peeling of Plaster on Wall No. 1 & 2 of Open Sky Area No.2 of First Floor

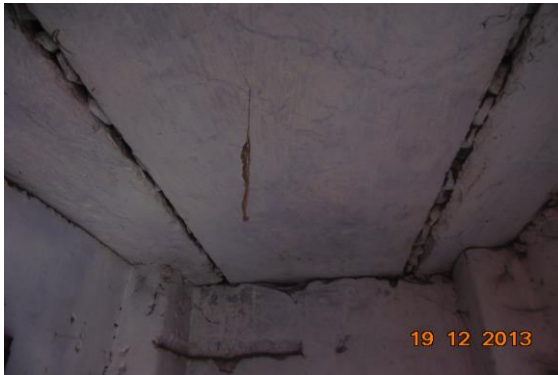
Photo 71

Peeling of Plaster on Roof of Bathroom of Parshu Ram Public School, First Floor

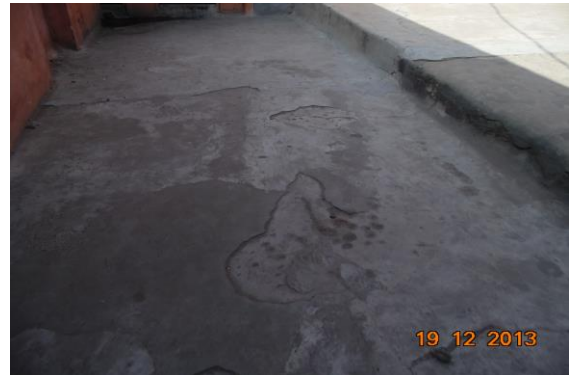
Photo 72

Peeling of Plaster on Floor of Open Sky Area No.3 of First Floor

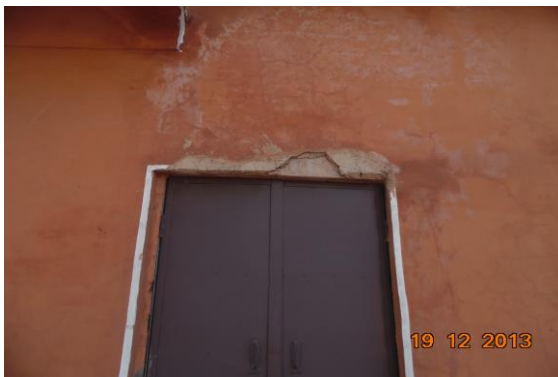
Photo 73

Peeling of Plaster on Front side Wall of Parshu Ram Public School of First Floor

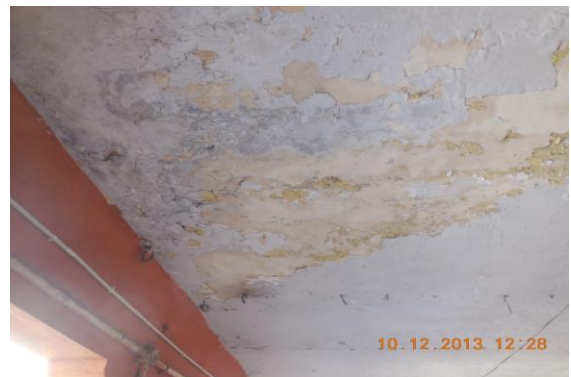
Photo 74

Dampness/Seepage on Roof of Varanda of Shop No.364A of Ground Floor

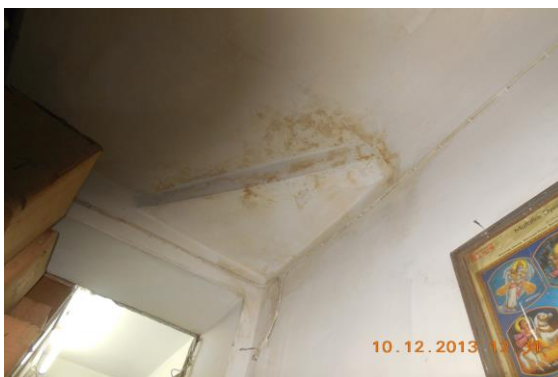
Photo 75

Dampness/Seepage on Roof of Varanda of Shop No.364A of Ground Floor

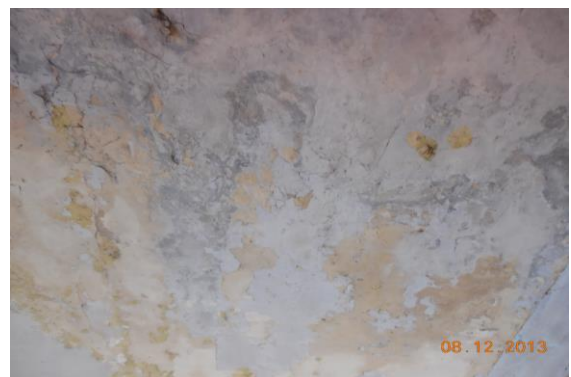
Photo 76

Dampness/Seepage on Roof of Varanda of Shop No.364B of Ground Floor

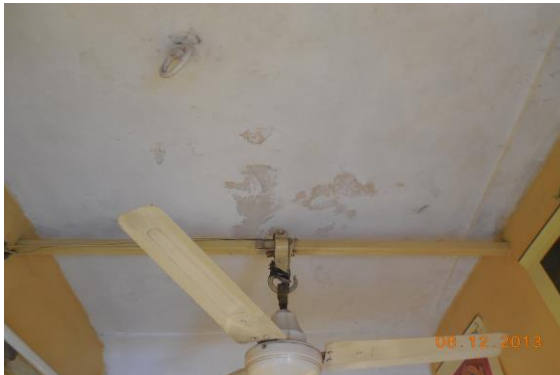
Photo 77

Peeling of Plaster on Roof of Varanda of Shop No.364B of Ground Floor

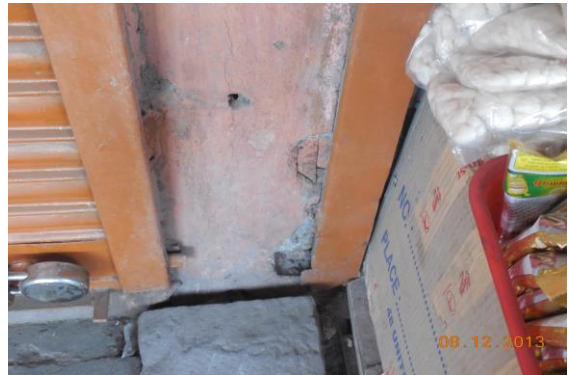
Photo 78

Peeling of Plaster on Leftside External Column of Varanda of Shop No.365 of Ground Floor

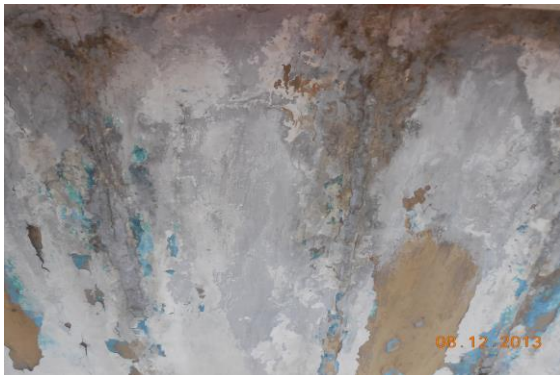
Photo 79

Dampness/Seepage on Roof of Varanda of Shop No.365 of Ground Floor

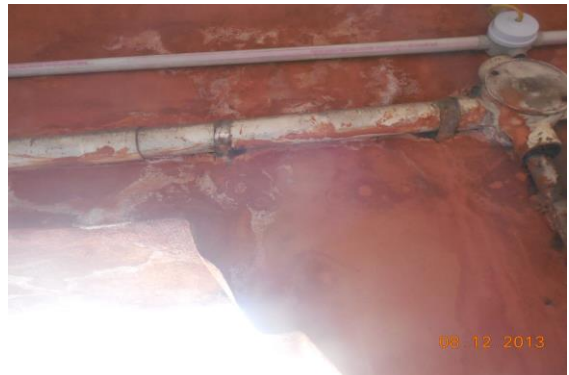
Photo 80

Dampness/Seepage on Beam of Varanda of Shop No.365 of Ground Floor

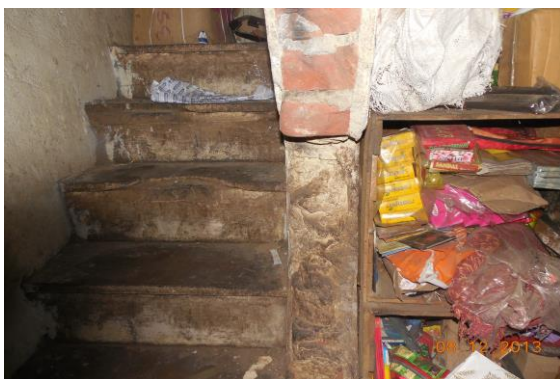
Photo 81

Damaged Portion on Wall No. 1 of Staircase Area of Basement

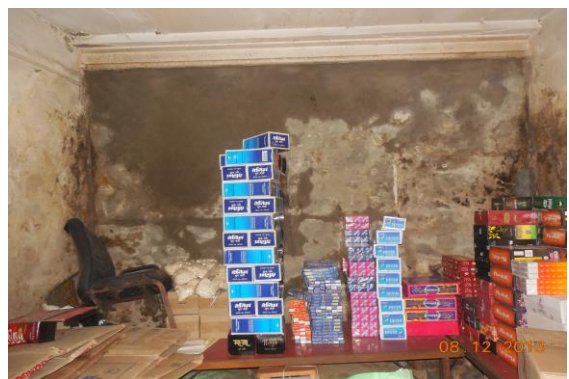
Photo 82

Dampness/Seepage on Wall No. 1, 2 & 4 of Staircase Area of Basement

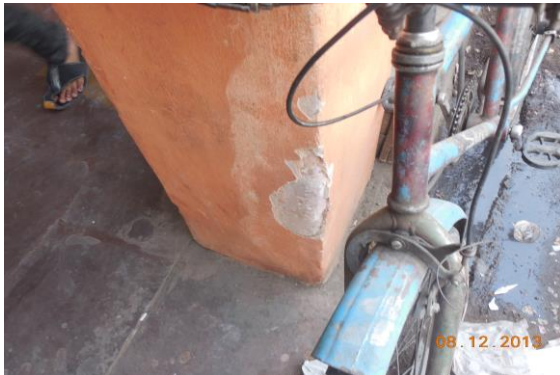
Photo 83

Peeling of Plaster on Right side External Column of Varanda of Shop No.366 of Ground Floor

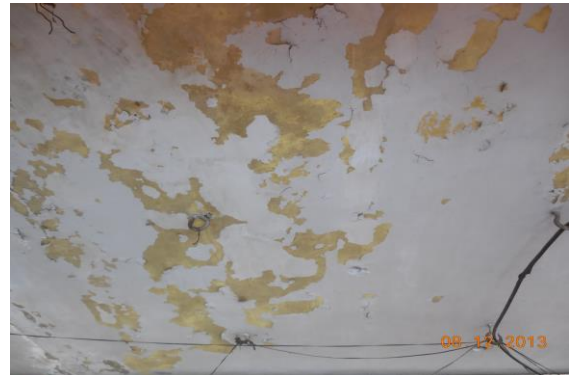
Photo 84

Dampness/Seepage on Roof of Varanda of Shop No.366 of Ground Floor

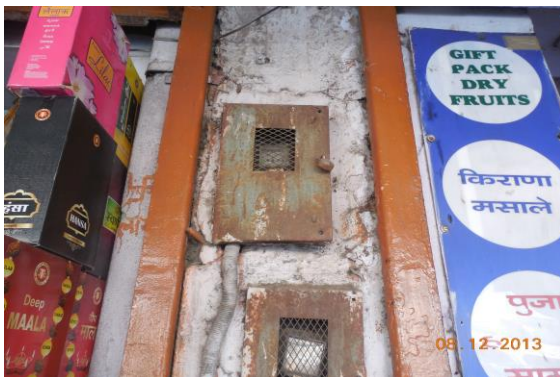
Photo 85

Damaged Portion on Leftside External Column of Varanda of Shop No.366 of Ground Floor

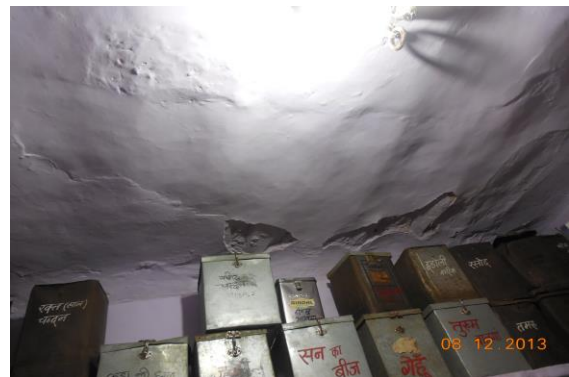
Photo 86

Damaged Portion on Roof of Part C of Shop No.366 of Ground Floor

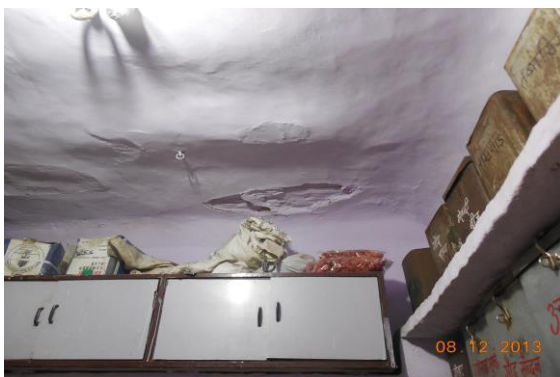
Photo 87

Damaged Portion on Roof of Part C of Shop No.366 of Ground Floor

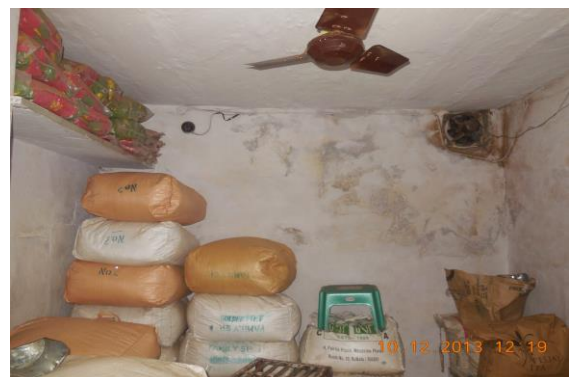
Photo 88

Peeling of Plaster on Wall No. 4 of Shop no.367 of Basement

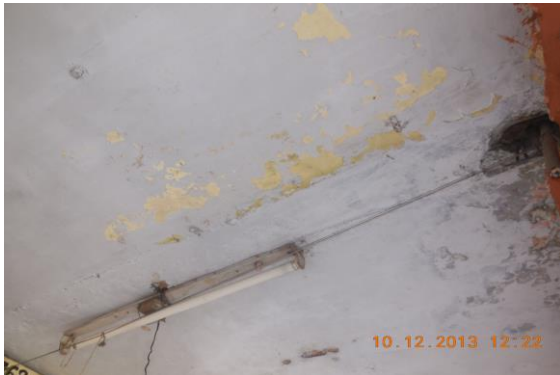
Photo 89

Peeling of Plaster on Roof of Varanda of Shop no.367, Ground Floor

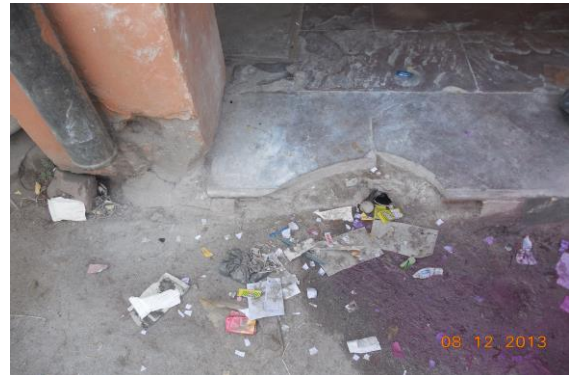
Photo 90

Damaged Portion on Front side outer Wall No.3 & Floor of Varanda of Shop No.368, Ground Floor

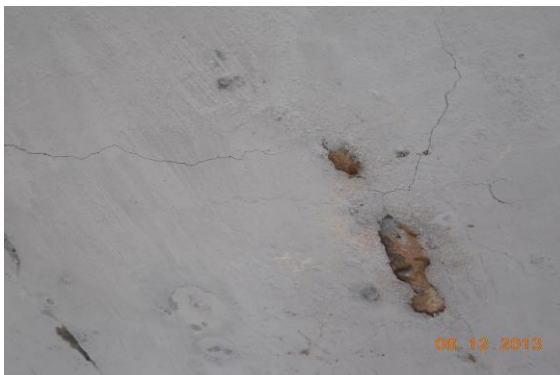
Photo 91

Damaged Portion on Roof of Varanda of Shop No.368, Ground Floor

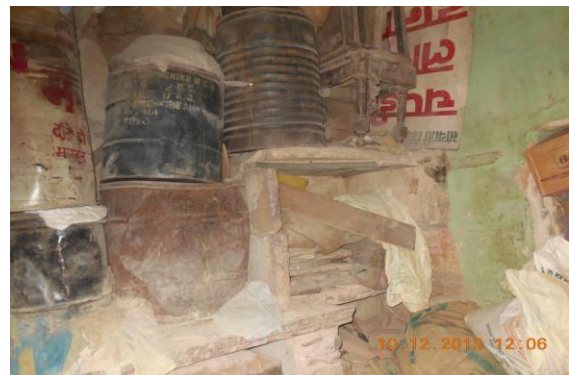
Photo 92

Peeling of Plaster on Wall No. 1 of Part B of Shop No.369, Ground Floor

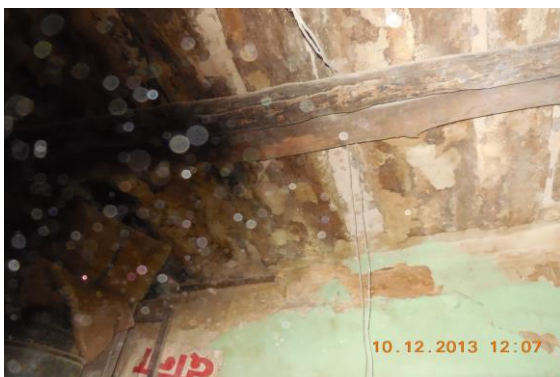
Photo 93

Peeling of Plaster on Roof of Part B of Shop No.369, Ground Floor

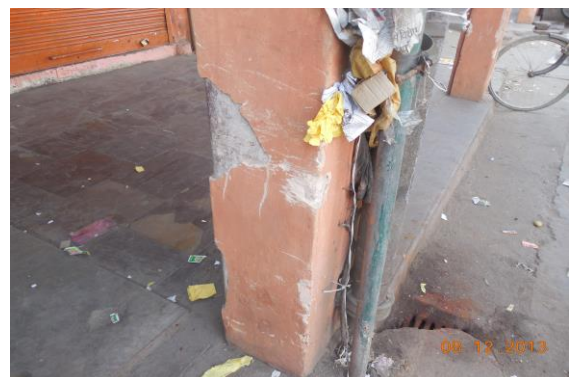
Photo 94

Peeling of Plaster on Right side External Column of Varanda of Shop No.370, Ground Floor

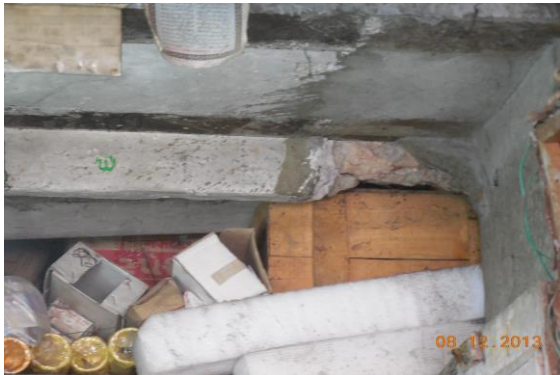
Photo 95
Damaged Portion on Roof of Shop No.370 of Ground Floor

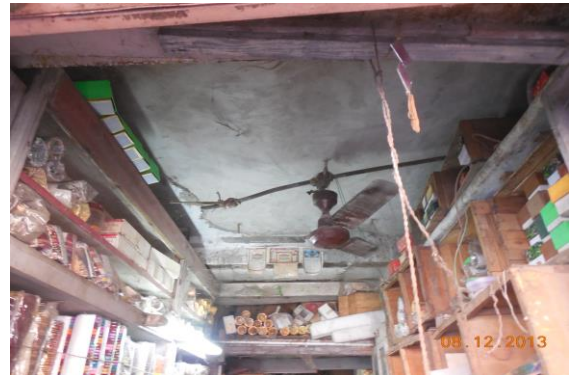
Photo 96
Peeling of Plaster on Roof of Shop No.370 of Ground Floor

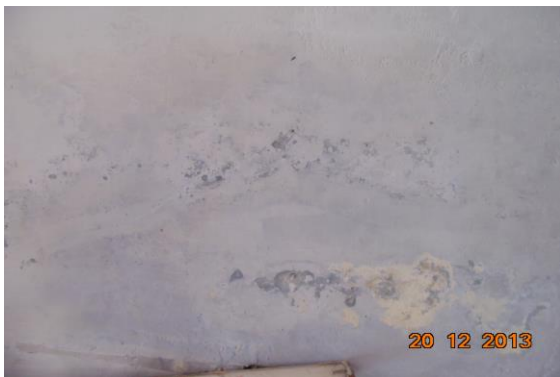
Photo 97
Dampness/Seepage on Roof of Vrandah of Shop no. 371, Ground Floor

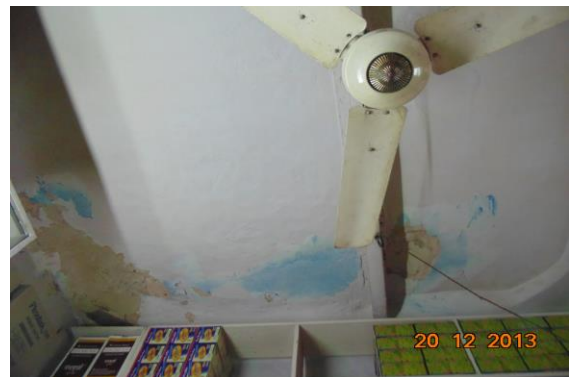
Photo 98
Peeling of Plaster on Roof of Part-B of Shop no. 371, Ground Floor

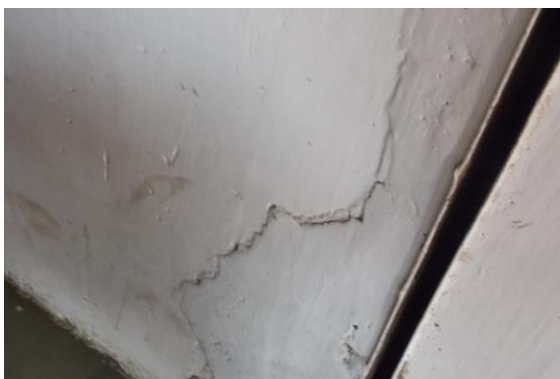
Photo 99
Plaster Crack on Roof of Shop No. 364A of Ground Floor

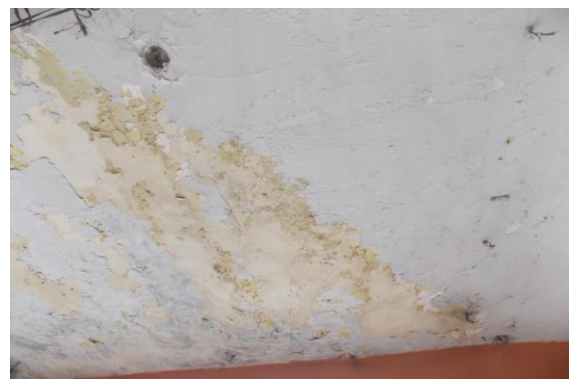
Photo 100
Peeling of Plaster on Roof of Shop No. 364A of Ground Floor

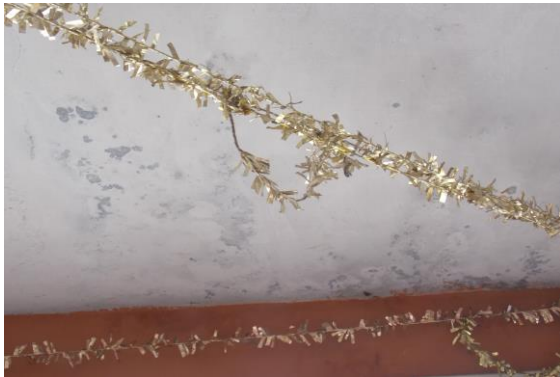
Photo 101

Peeling of Plaster on Roof of Star Bangles of Ground Floor

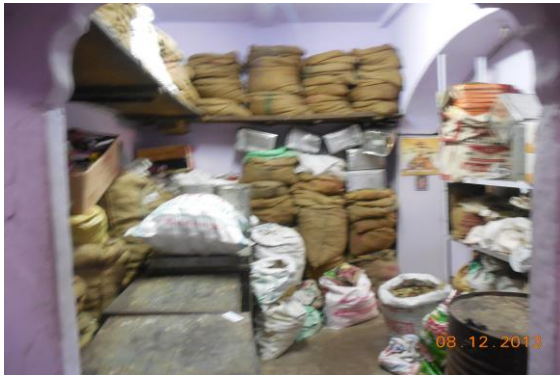
Photo 125

All Walls of Part D of Shop No.366 of Ground Floor Covered With Material

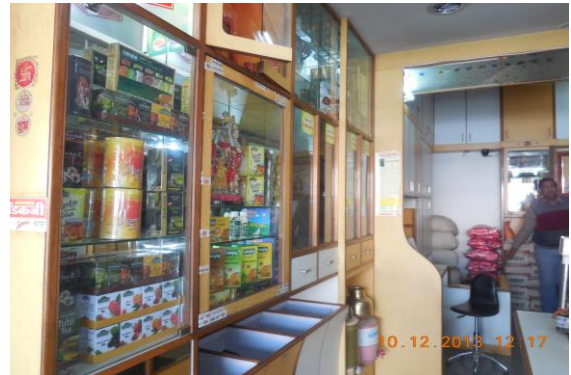
Photo 126

Wall No. 1 of Shop no.367 of Ground Floor Covered With Glass Work & Material

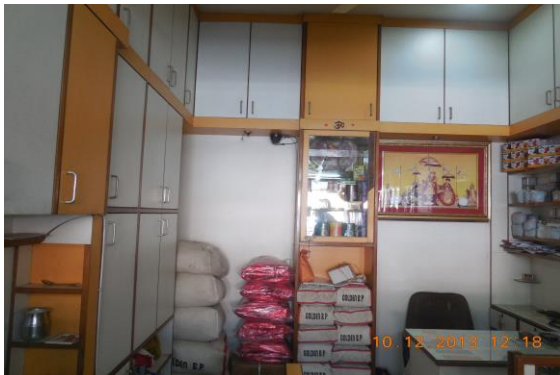
Photo 127

Wall No. 4 of Shop no.367 of Ground Floor Covered With Glass Work & Material

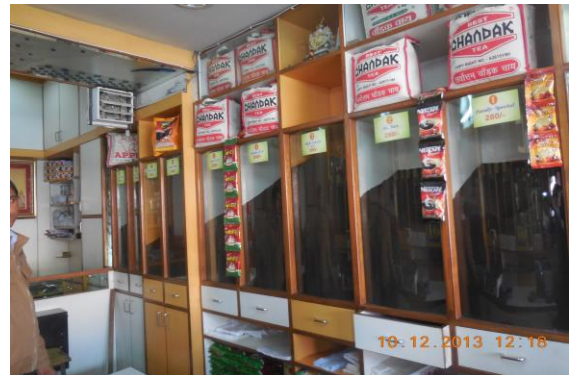
Photo 128

Wall No. 2 of Shop no.367 of Ground Floor Covered With Glass Work & Material

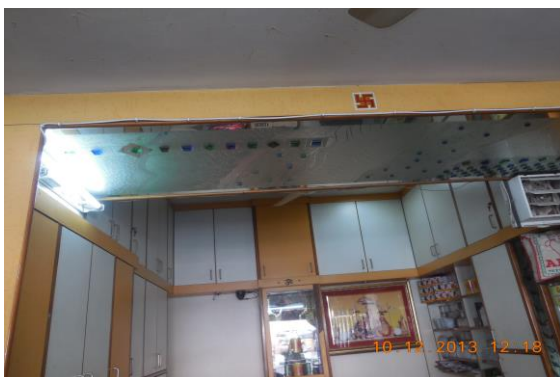
Photo 129

Roof of Shop no.367 of Ground Floor Covered With Falls Ceiling

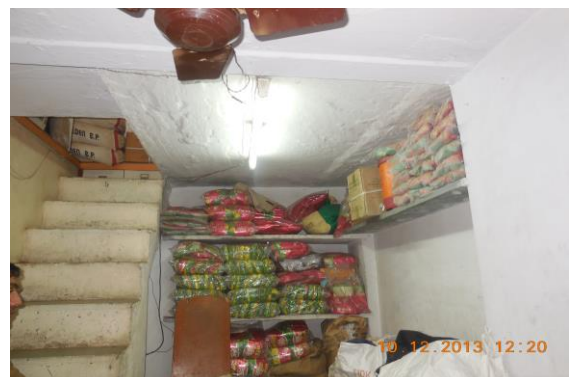
Photo 130

Roof of Shop no.367 of Basement Covered With Falls Ceiling

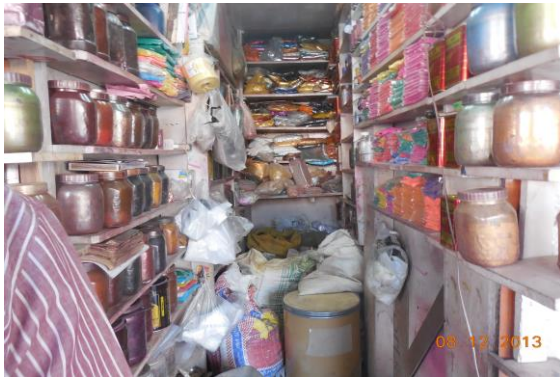
Photo 131

All Walls & Roof of Shop No.368 of Shop No.368, Ground Floor Covered With Racks & Material

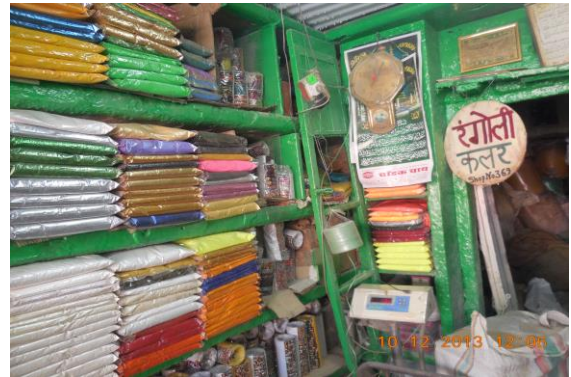
Photo 132

Wall No. 1 of Part A of Shop No.369, Ground Floor Covered With material

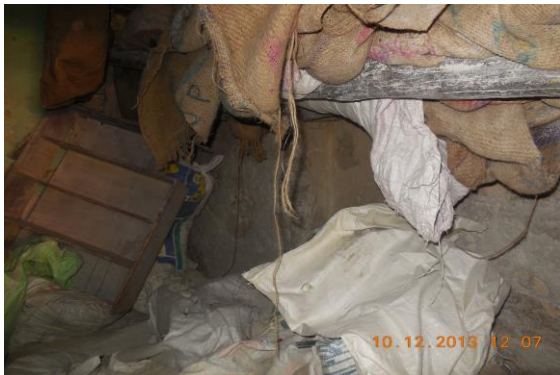
Photo 133

Wall No. 2 of Part B of Shop No.369, Ground Floor Covered With material

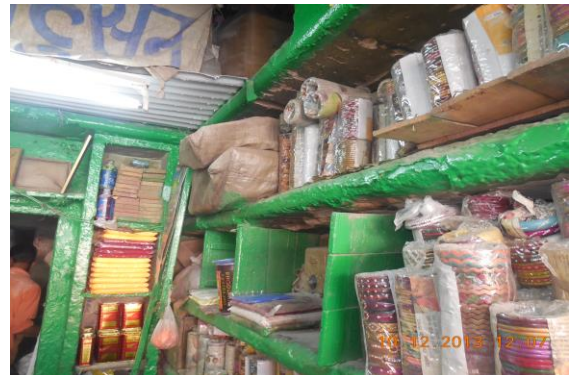
Photo 134

Wall No. 2 of Part A of Shop No.369, Ground Floor Covered With material

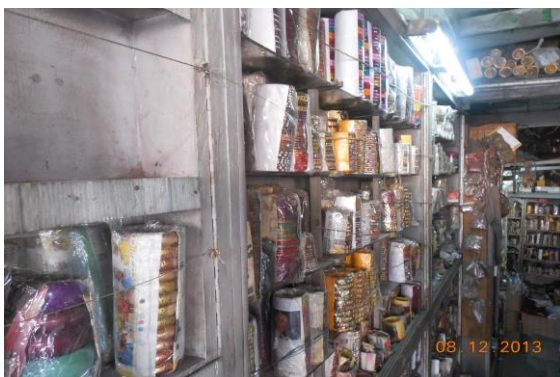
Photo 135

Wall No. 1 of Shop No.370 of Ground Floor Covered With wooden Racks & Material

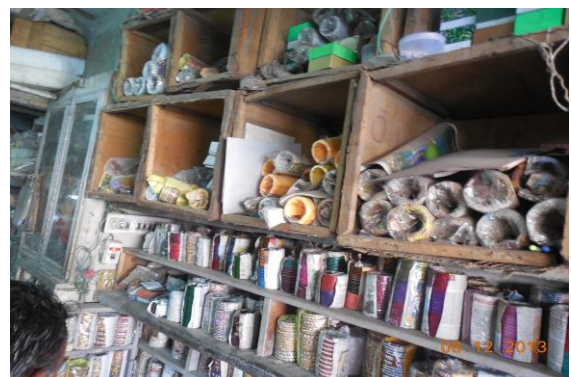
Photo 136

Wall No. 2 of Shop No.370 of Ground Floor Covered With wooden Racks & Material

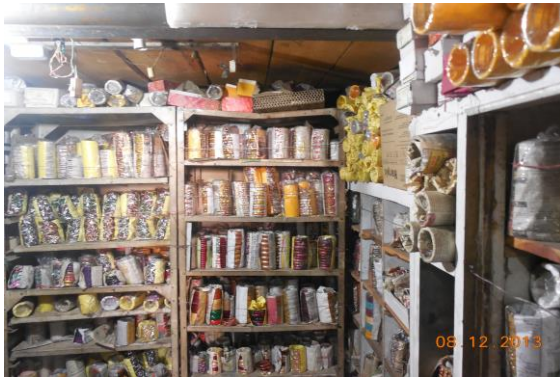
Photo 137

Wall No. 2, 4 & Backside of Shop No.370 of Ground Floor Covered With wooden Racks & Material

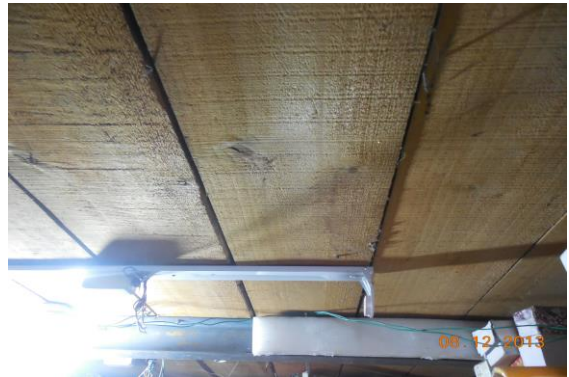
Photo 138

Roof & Backside of Shop No.370 of Ground Floor Covered With wooden Work

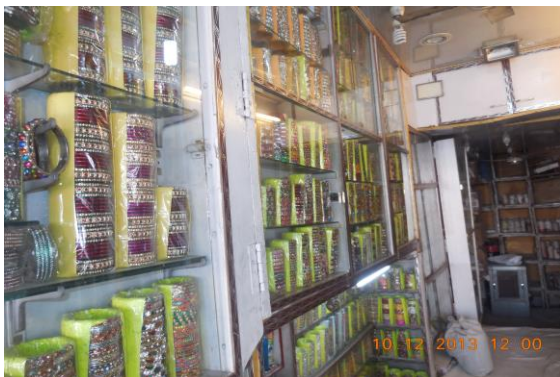
Photo 139

Wall No. 1 of Shop No.370A of Ground Floor Covered With Glass Work & Material

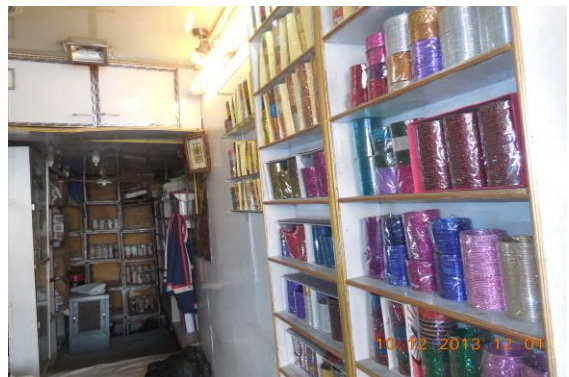
Photo 140

Wall No. 2 & 4 of Shop No.370A of Ground Floor Covered With Glass Work & Material

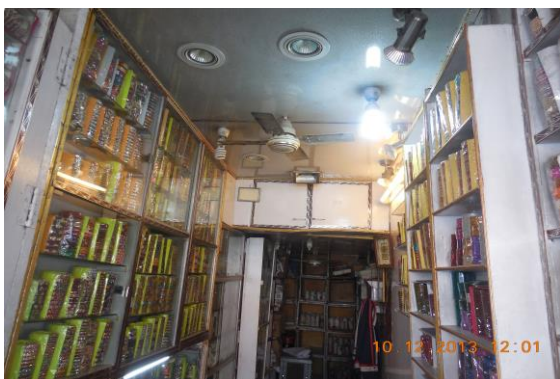
Photo 141

Roof of Shop No.370A of Ground Floor Covered With Wooden Work

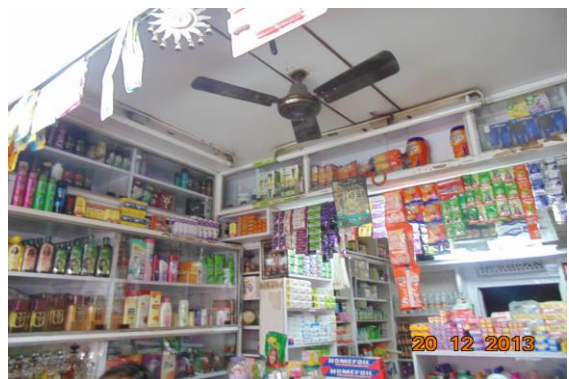
Photo 142

Wall No. 1 of Part-A of Shop no. 371, Ground Floor Covered with Material

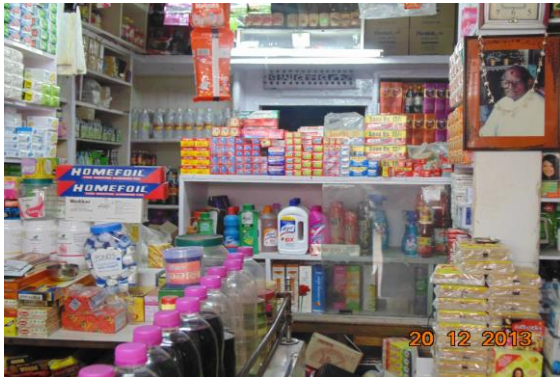
Photo 143

Wall No. 4 of Part-A of Shop no. 371, Ground Floor Covered with Material

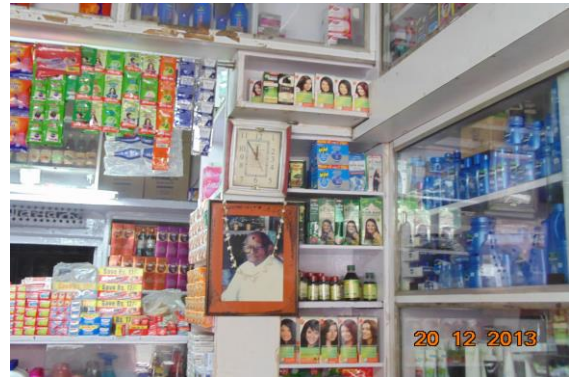
Photo 144

Wall No. 2 of Part-A of Shop no. 371, Ground Floor Covered with Material

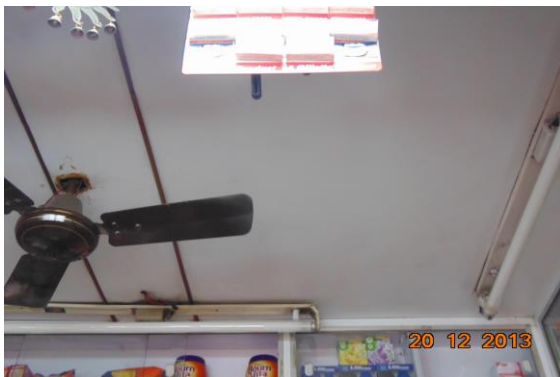
Photo 145

Roof of Part-A of Shop no. 371, Ground Floor Covered with Wooden

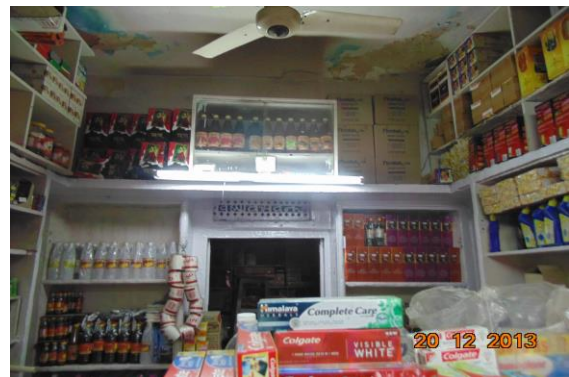
Photo 146

All walls of Part-B of Shop no. 371, Ground Floor Covered with Wooden & Material

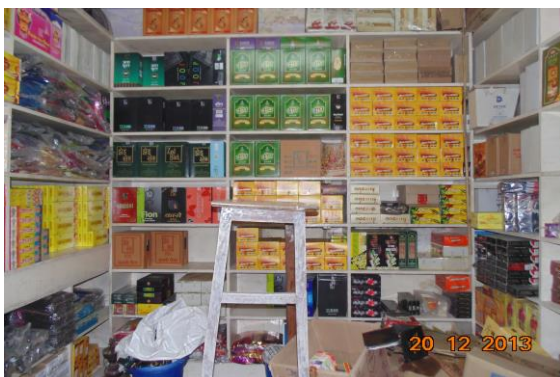
Photo 147

All walls of Part-C of Shop no. 371, Ground Floor Covered with Wooden & Material

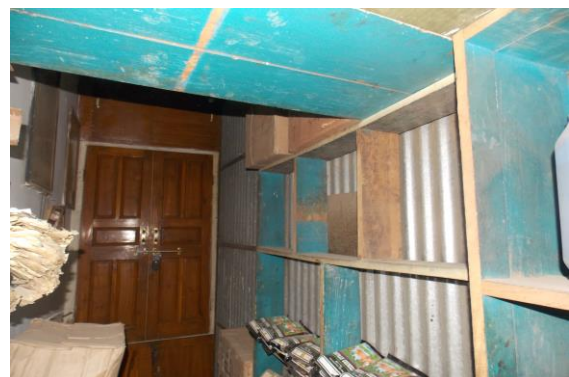
Photo 148

All Walls of Shop No. 364A of Ground Floor Covered with Material

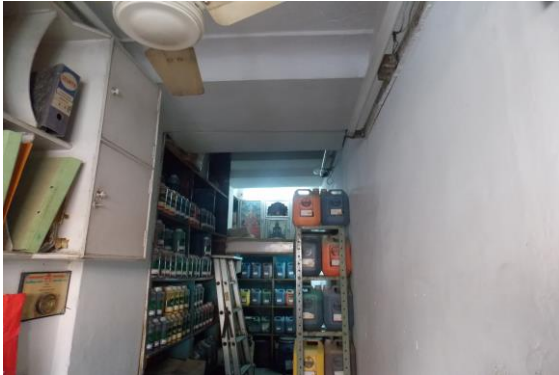
Photo 149

All Walls of Shop No. 364A of Ground Floor Covered with Material

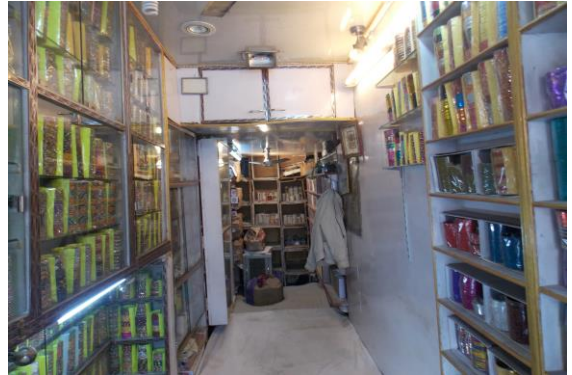
Photo 150

All Walls of Star Bangles of Ground Floor Covered with Material

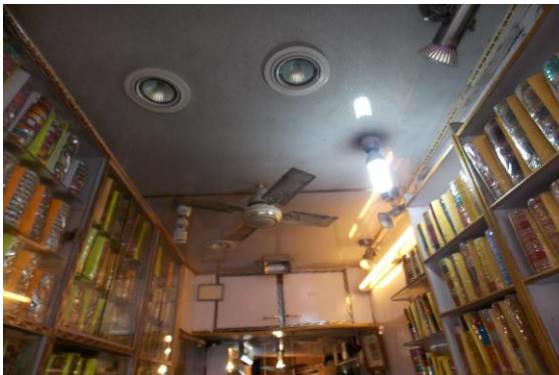
Photo 151

All Walls of Star Bangles of Ground Floor Covered with Material

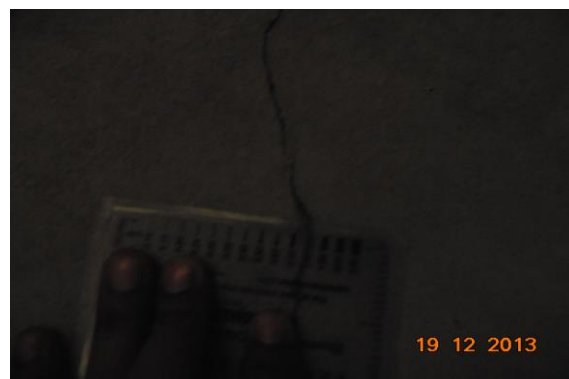
Photo 11A
Inclined Crack on Wall No. 2 of Part B of Shop Shyam Store, Ground Floor Approx. Width = 1mm, Approx. Length = 1m. Distance from Wall No.4 = 1.5m, Height from Floor = 0.7m.

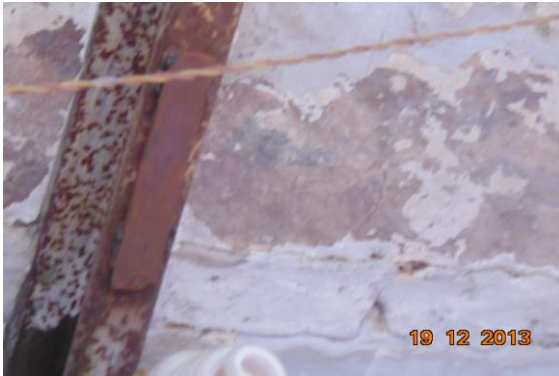
Photo 12

Dampness/Seepage on Shade of Shop Chandra Treaders of Ground Floor

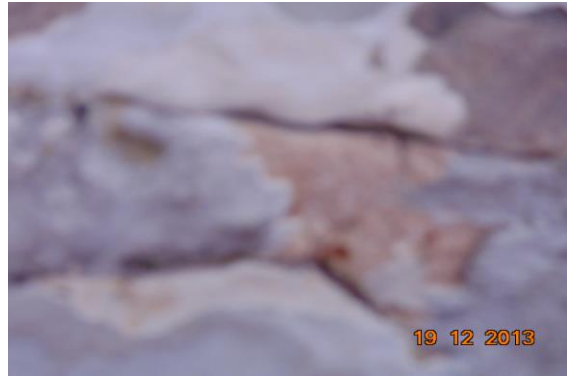
Photo 13

Peeling of Plaster on shade of Shop Chandra Treaders of Ground Floor

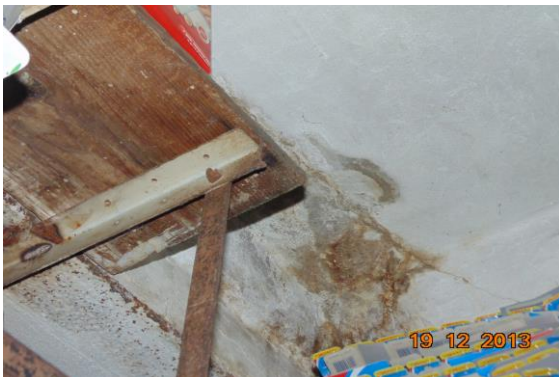
Photo 14

Dampness/Seepage on Wall No. 2 of Shop Chandra Treaders of Ground Floor

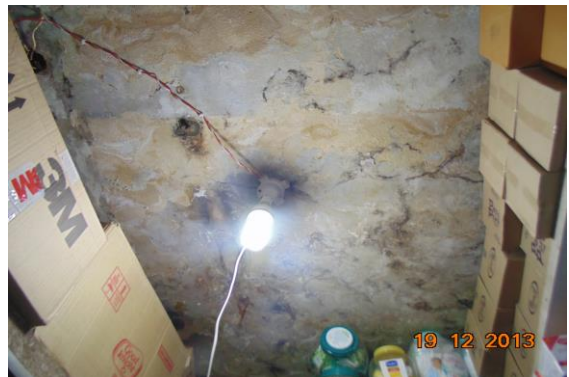
Photo 15

Dampness/Seepage on Wall No. 2 of Shop Chandra Treaders of Ground Floor

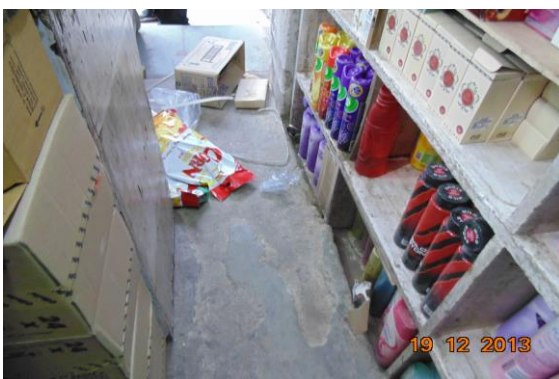
Photo 16

Peeling of Plaster on Floor of Shop Chandra Treaders of Ground Floor

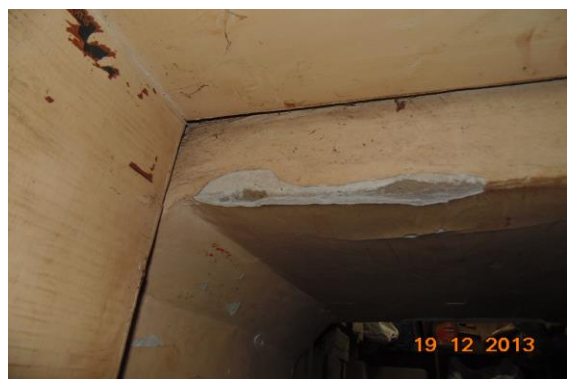
Photo 17

Peeling of Plaster on Wall No. 4 of Part A of Shop Shyam Store of Ground Floor

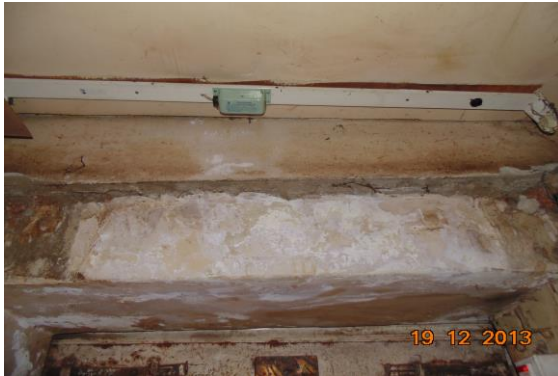
Photo 18

Damaged Portion on Wall No. 3 of Part A of Shop Shyam Store of Ground Floor

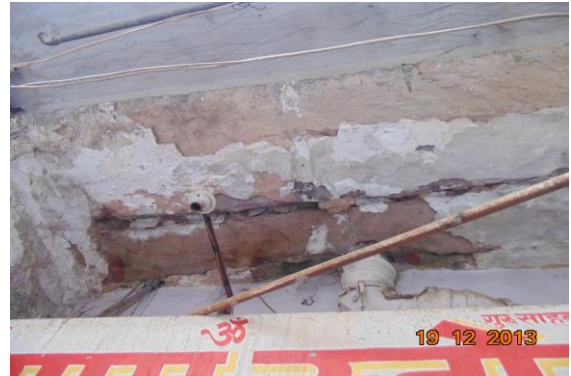
Photo 19

Damaged Portion on Shade of Shop Shyam Store of Ground Floor

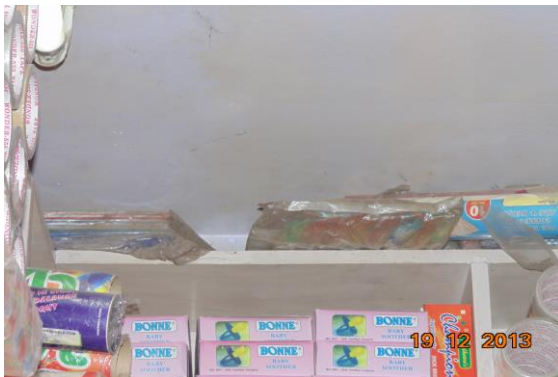
Photo 20

Dampness/Seepage on Roof of Shop Hind Treaders of Ground Floor

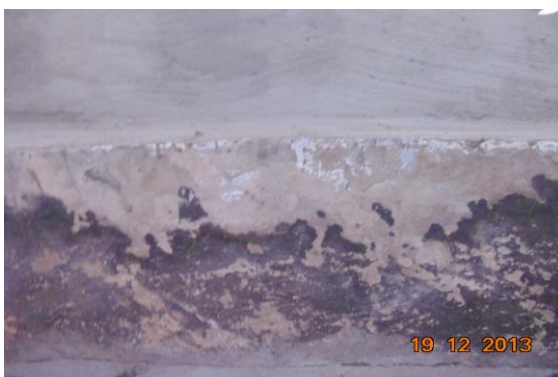
Photo 22

Peeling of Plaster on Front Shade of Shop Hind Treaders of Ground Floor

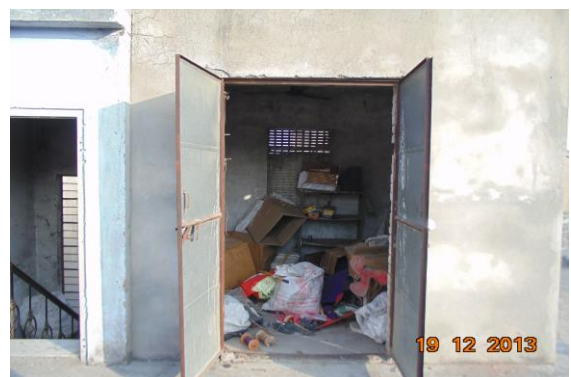
Photo 23

Peeling of Plaster on Front Wall of Shop Radha Gobind Enterprises of Third Floor

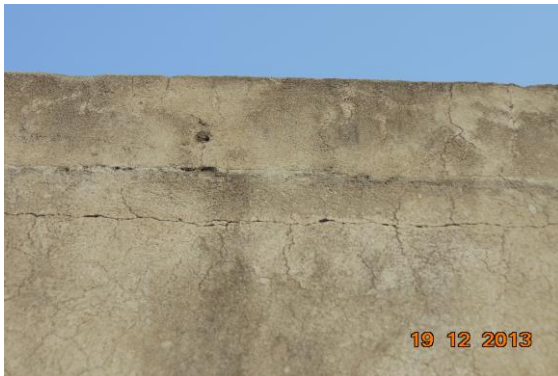
Photo 24
Peeling of Plaster on Shop Radha Gobind Enterprises of Terrace

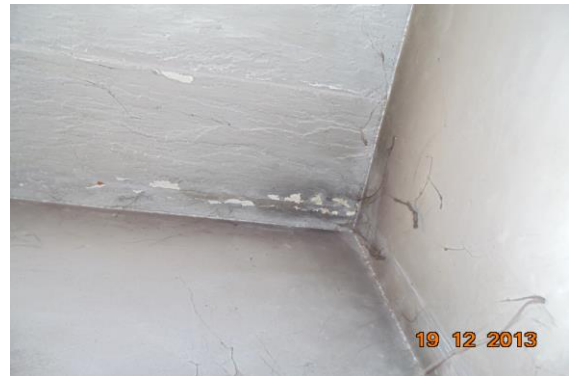
Photo 25
Peeling of Plaster on Roof of Staircase Second Floor To Third Floor of Terrace

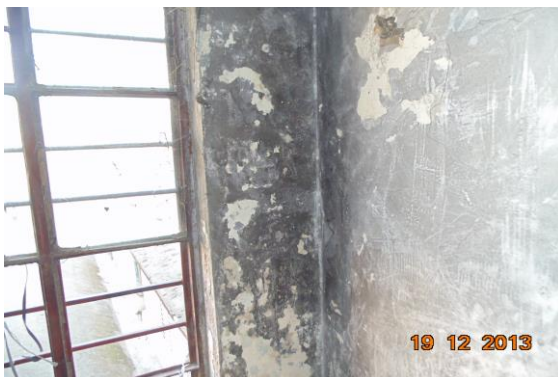
Photo 26
Peeling of Plaster on Wall No. 4 of Staircase Second Floor To Third Floor of Terrace

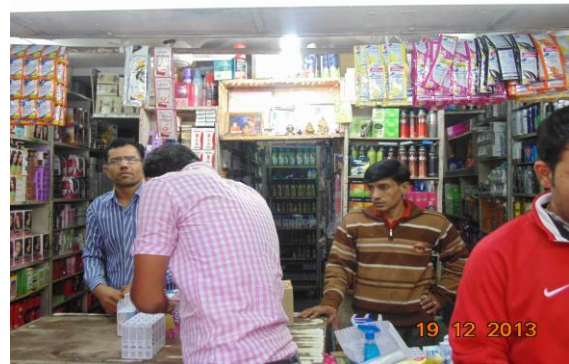
Photo 27
All walls of Shop Chandra Treaders of Ground Floor Covered With Material

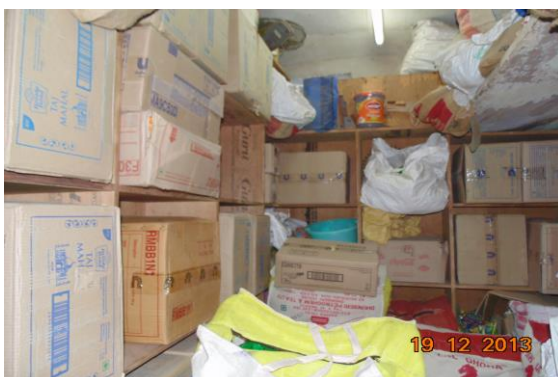
Photo 28
All walls of Part B of Shop Shyam Store of Ground Floor Covered With Material

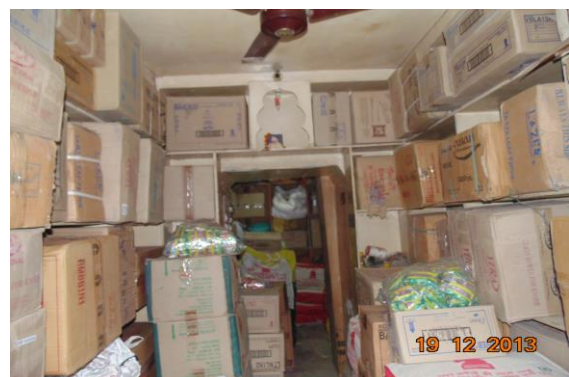
Photo 29
All walls of Part A of Shop Shyam Store of Ground Floor Covered With Material

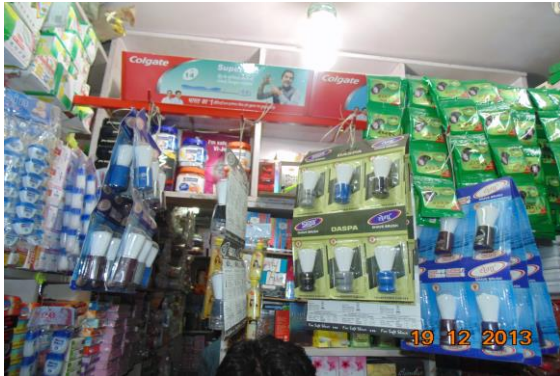
Photo 30
All walls of Shop Hind Treaders of Ground Floor

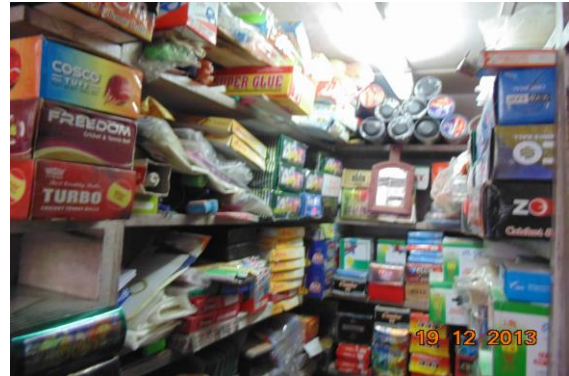
Photo 31
All walls of Shop Radha Gobind Enterprises of Ground Floor Covered With Material

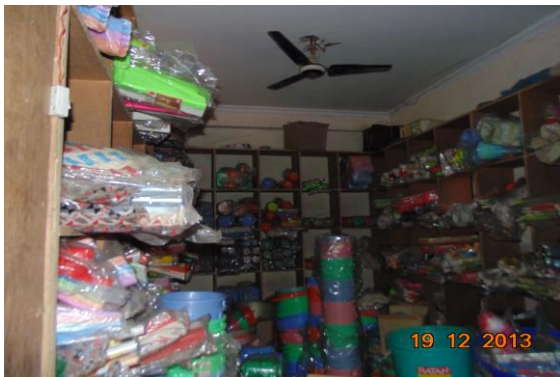
Photo 32
All walls of Shop Radha Gobind Enterprises of Ground Floor Covered With Material

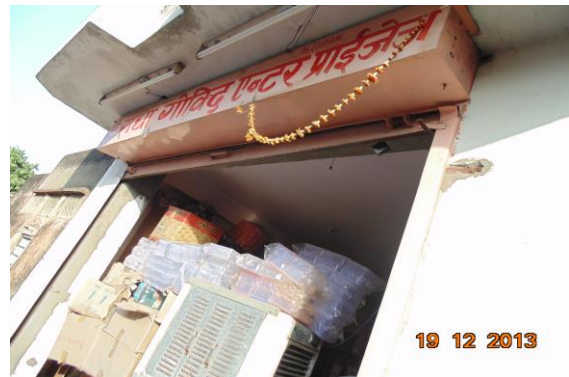
Photo 33
All walls of Shop Radha Gobind Enterprises of Third Floor Covered With Material

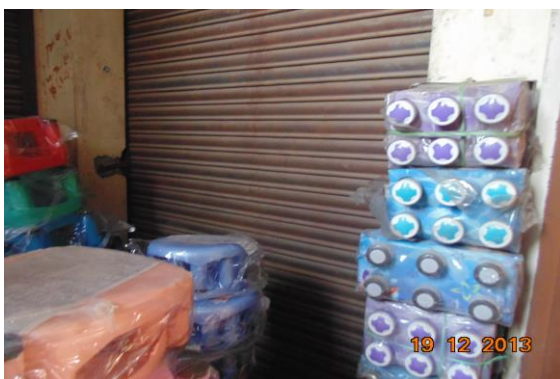
Photo 34
Shop No.2 of Second Floor Locked

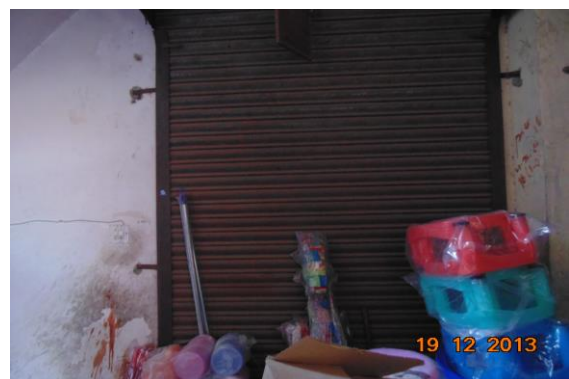
Photo 35
Shop No.3 of Second Floor Locked

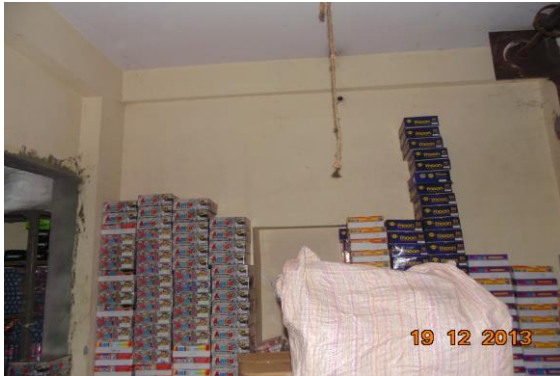
Photo 36

All walls of Shop No.3 of First Floor Covered With Material

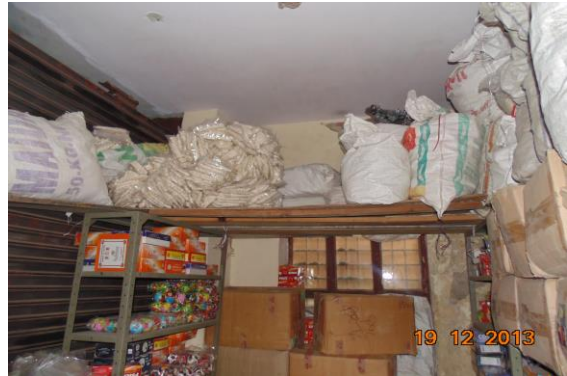
Photo 37

All walls of Shop No.4 of First Floor Covered With Material

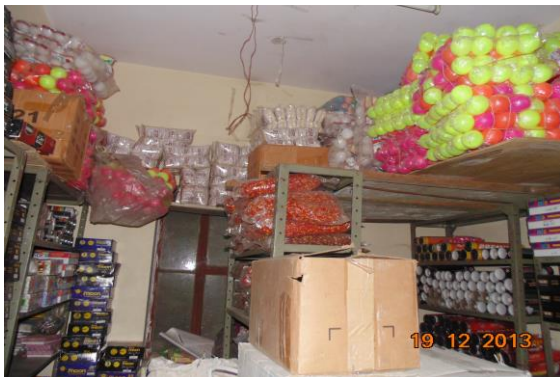
Photo 38

All walls of Shop No.5 of First Floor Covered With Material

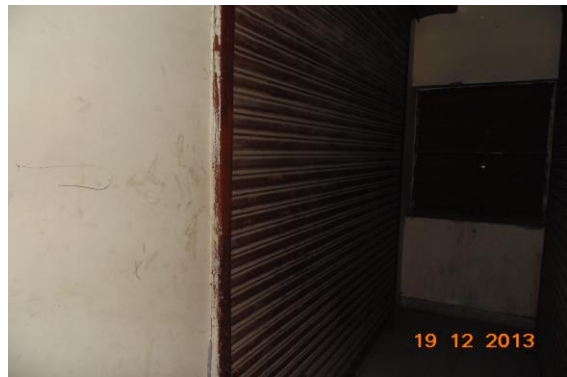
Photo 39

Shop No.6 of First Floor Locked
