Pre Building Condition Survey Report

Name and Address of Structure :	Choti Chopar to Badi Chopar (Down Line)
---------------------------------	---

Name of the Project	Contract JMRC-UG1B “Design and Construction of Tunnel between Chandpole and Badi Chouper and reverse line by Shield TBM, Underground Metro Stations at Choti Chouper and Badi Chouper by Cut and Cover Methods on East West Corridor of Jaipur Metro Rail Corporation Limited .”	
Owner :

Pre Building Condition Survey Report Choti Chopar to Badi Chopar (Down Line)

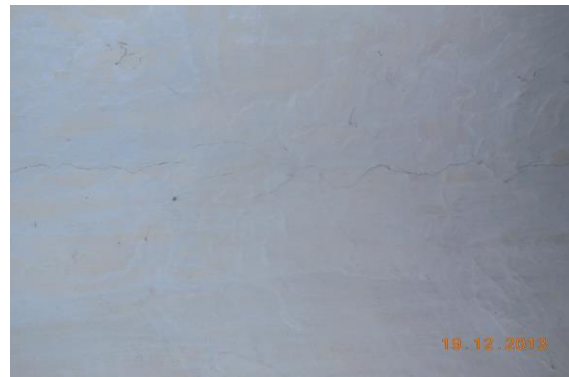
Summary of Cracks						
Defect ID	Location	Orientation	Appx. Width (mm)	Appx. Length (m)	Category	Photo No.
1	Roof Room No. 2 First Floor	Horizontal	0.3	2.6	Very Slight	4
2	Wall No. 4 Open Varanda No.1 Second Floor	Inclined	1.5	1	Slight	5, 5A
3	Wall No. 4 Open Varanda No.1 Second Floor	Inclined	1.5	0.5	Slight	6, 6A
4	Wall No. 3 Open Varanda No.1 Second Floor	Inclined	1	1.1	Slight	7, 7A
5	Wall No. 4 Room No. 3 Second Floor	Horizontal	0.5	2	Very Slight	8
6	Wall No. 3 Open Varanda No.2 Second Floor	Inclined	0.5	1.5	Very Slight	9, 9A

Photo 4
Horizontal Crack on Roof of Room No. 2, First Floor
Approx. Width = 0.3mm, Approx. Length = 2.6m.
Distance from Wall N0.1 = 0.1m, Height from Floor = 2.3m.

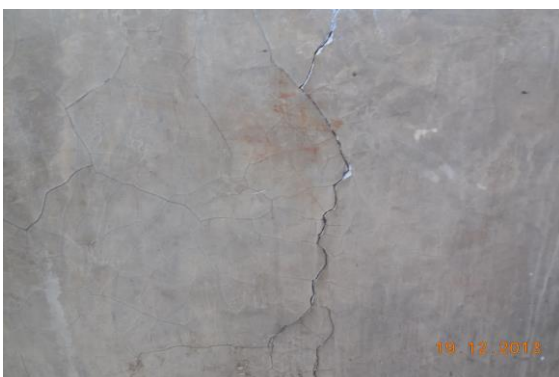
Photo 5
Inclined Crack on Wall No. 4 of Open Varanda No.1, Second Floor
Approx. Width = 1.5mm, Approx. Length = 1m.
Distance from Wall No.2 = 0.9m, Height from Floor = 0m.

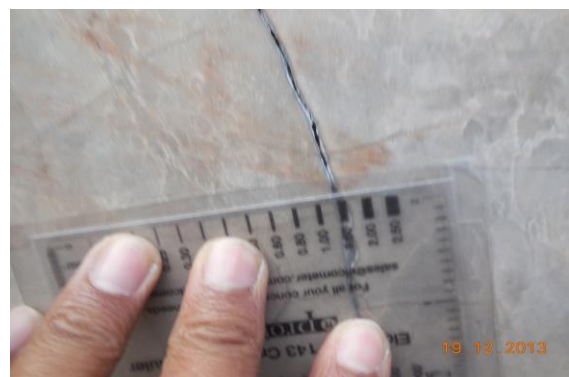
Photo 5A
Inclined Crack on Wall No. 4 of Open Varanda No.1, Second Floor
Approx. Width = 1.5mm, Approx. Length = 1m.
Distance from Wall No.2 = 0.9m, Height from Floor = 0m.

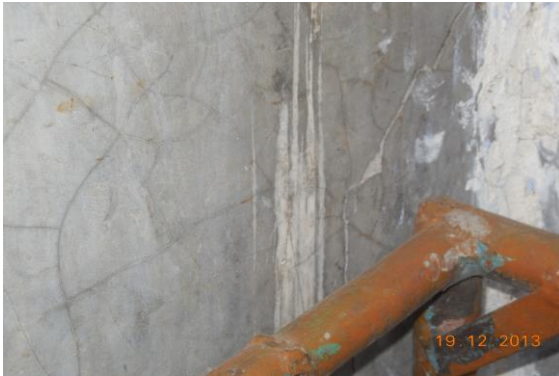
Photo 6

Inclined Crack on Wall No. 4 of Open Varanda No.1, Second Floor
Approx. Width = 1.5mm, Approx. Length = 0.5m.
Distance from Wall No.2 = 0.1m, Height from Floor = 0m.

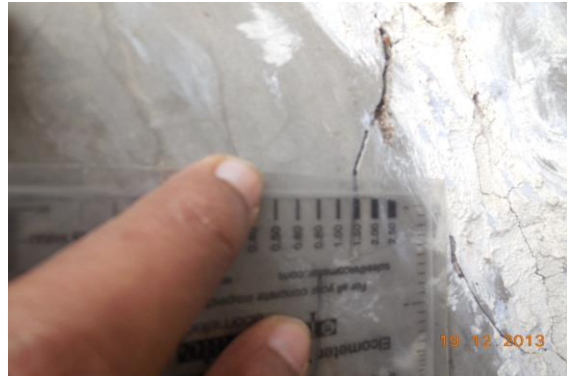
Photo 6A

Inclined Crack on Wall No. 4 of Open Varanda No.1, Second Floor
Approx. Width = 1.5mm, Approx. Length = 0.5m.
Distance from Wall No.2 = 0.1m, Height from Floor = 0m.

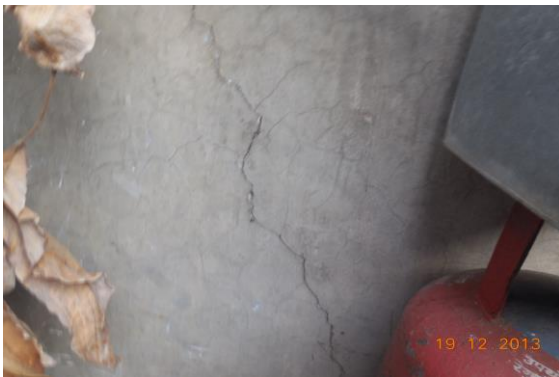
Photo 7

Inclined Crack on Wall No. 3 of Open Varanda No.1, Second Floor
Approx. Width = 1mm, Approx. Length = 1.1m.
Distance from Wall No.2 = 0.9m, Height from Floor = 0m.

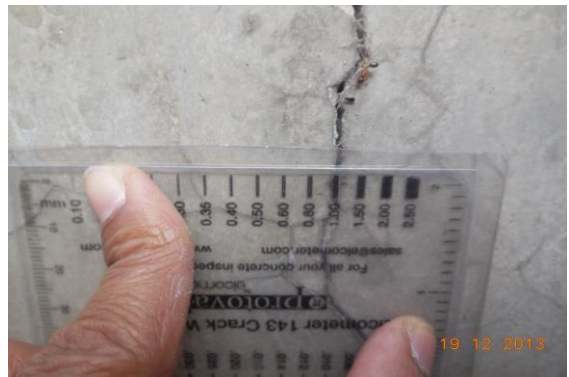
Photo 7A

Inclined Crack on Wall No. 3 of Open Varanda No.1, Second Floor
Approx. Width = 1mm, Approx. Length = 1.1m.
Distance from Wall No.2 = 0.9m, Height from Floor = 0m.

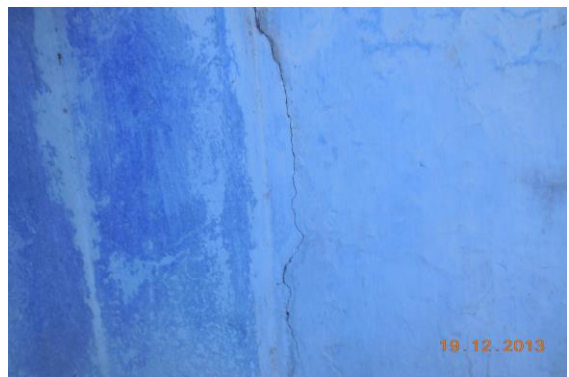
Photo 9

Inclined Crack on Wall No. 3 of Open Varanda No.2, Second Floor
Approx. Width = 0.5mm, Approx. Length = 1.5m.
Distance from Wall No.1 = 0m, Height from Floor = 1m.

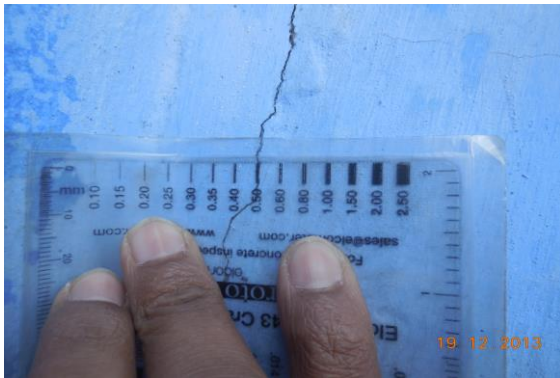
Photo 9A

Inclined Crack on Wall No. 3 of Open Varanda No.2, Second Floor
Approx. Width = 0.5mm, Approx. Length = 1.5m.
Distance from Wall No.1 = 0m, Height from Floor = 1m.

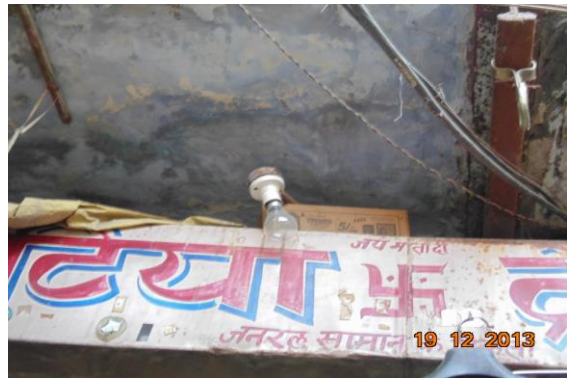
Photo 10

Dampness/Seepage on Roof Shade of Shop Bhatia Treaders of Ground Floor

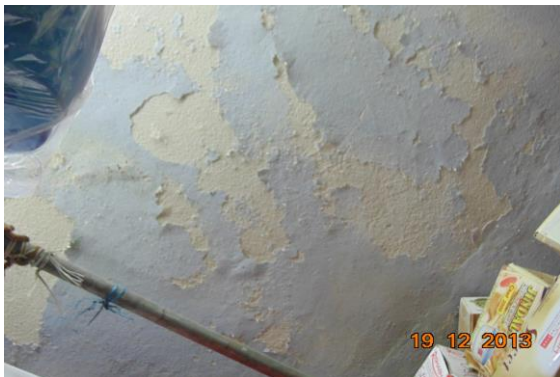
Photo 11

Dampness/Seepage on Roof of Shop Bhatia Treaders of Ground Floor

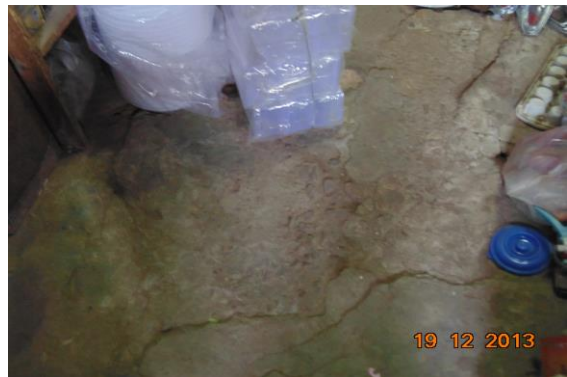
Photo 12

Peeling of Plaster on Floor of Shop Bhatia Treaders of Ground Floor

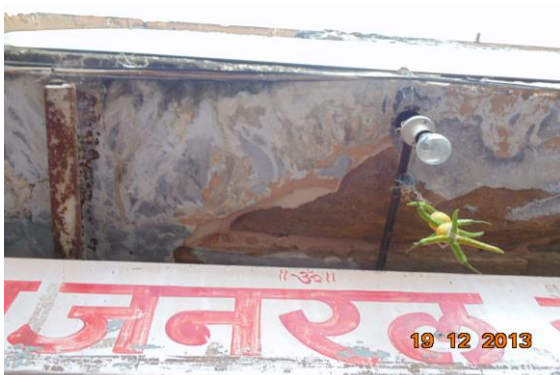
Photo 13

Damaged Portion on Front Side Roof of Shop Jaya General Store of Ground Floor

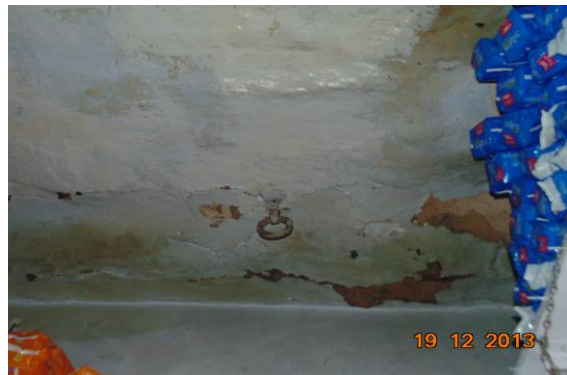
Photo 14

Peeling of Plaster on Roof of Shop Jaya General Store of Ground Floor

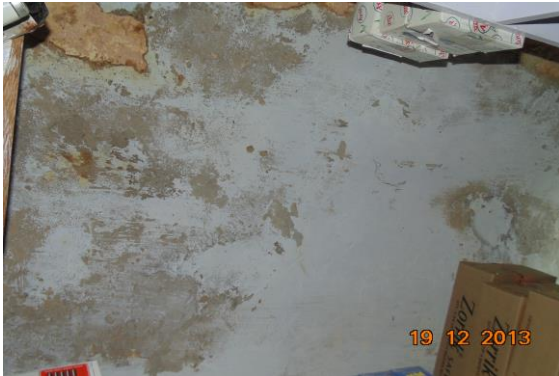
Photo 15

Peeling of Plaster on Roof of Shop Jaya General Store of Ground Floor

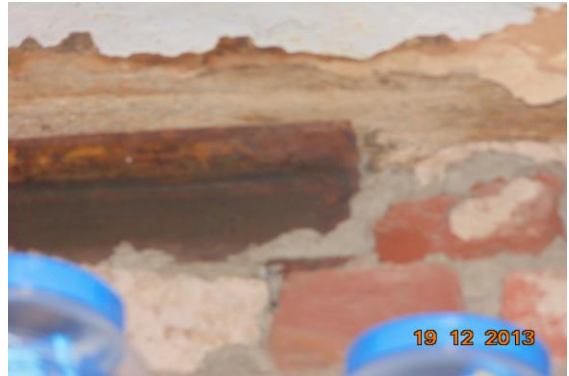
Photo 16

Damaged Portion on Wall No. 1 of Shop Jaya General Store of Ground Floor

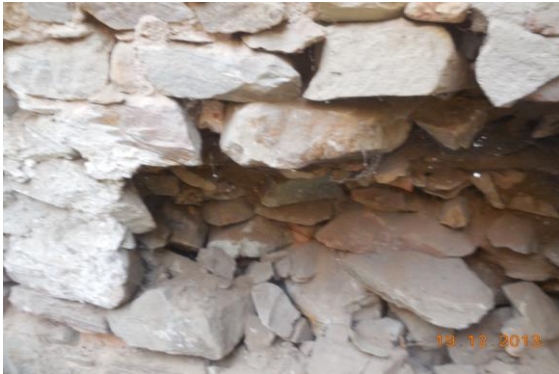
Photo 17

Damaged Portion on Wall No. 2 of Staircase Ground Floor To First Floor

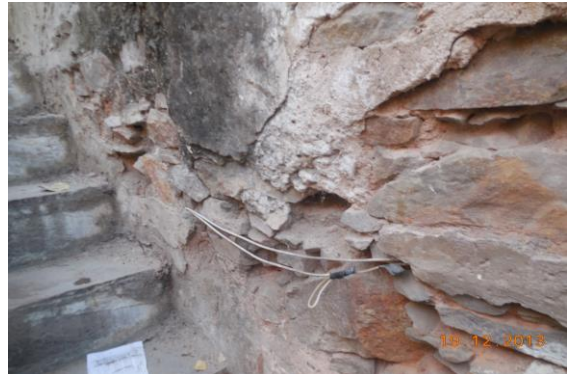
Photo 18

Damaged Portion on Wall No. 2 of Staircase Ground Floor To First Floor

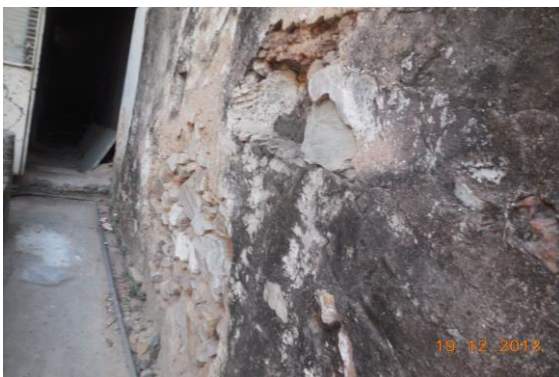
Photo 19

Damaged Portion on Wall No. 2 of Staircase Ground Floor To First Floor

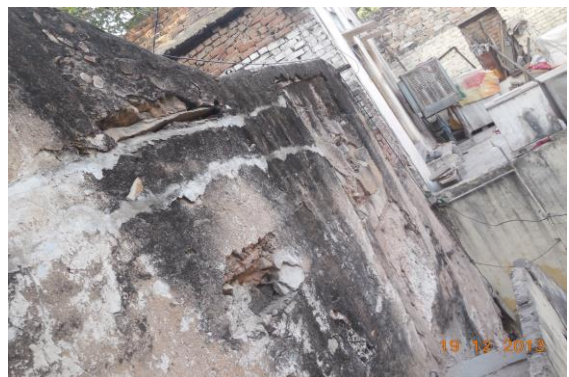
Photo 20

Damaged Portion on Wall No. 2 of Staircase Ground Floor To First Floor

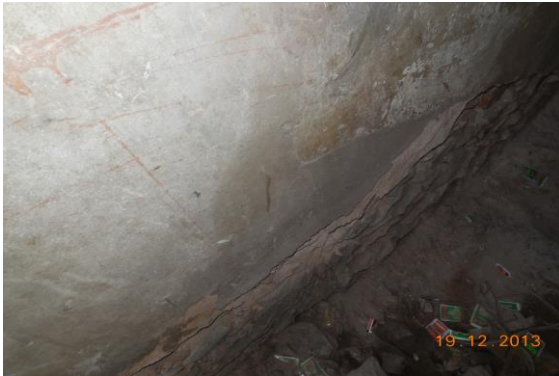
Photo 21
Damaged Portion on Wall No. 1 of Passage of First Floor

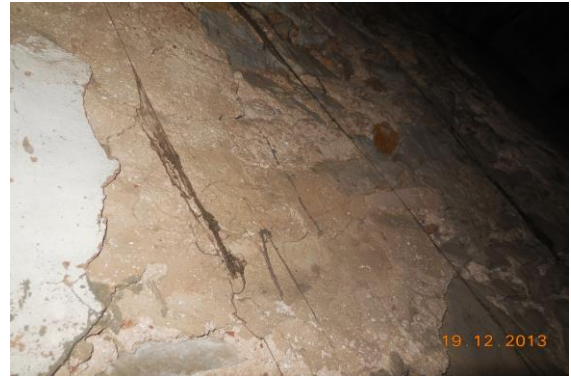
Photo 22
Damaged Portion on Wall No. 1 of Passage of First Floor

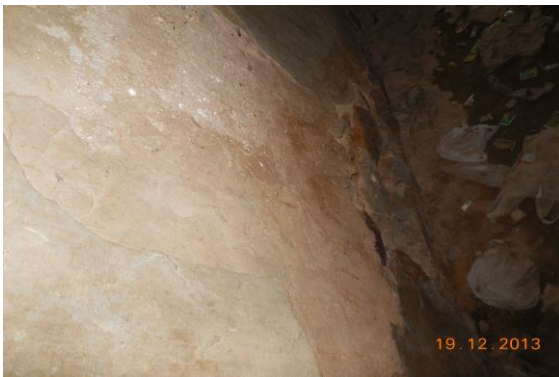
Photo 23
Damaged Portion on Wall No. 2 of Passage of First Floor

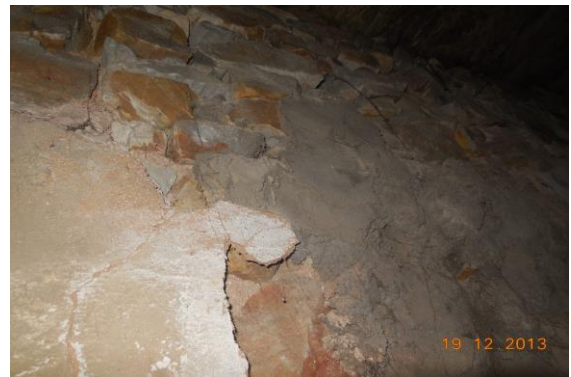
Photo 24
Damaged Portion on Wall No. 2 of Passage of First Floor

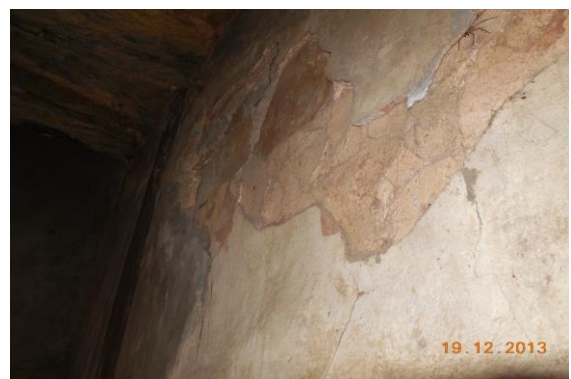
Photo 26
Damaged Portion on Wall No. 2 of Toilet No. 1 of First Floor

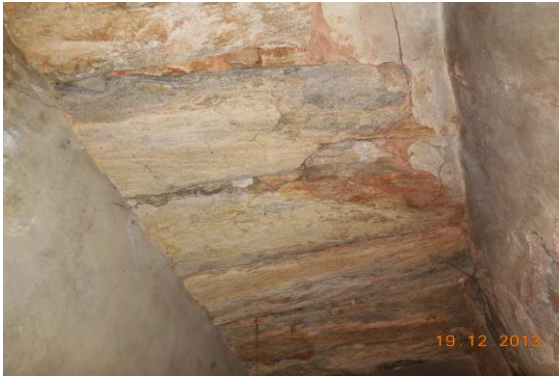
Photo 27
Damaged Portion on Roof of Toilet No. 1 of First Floor

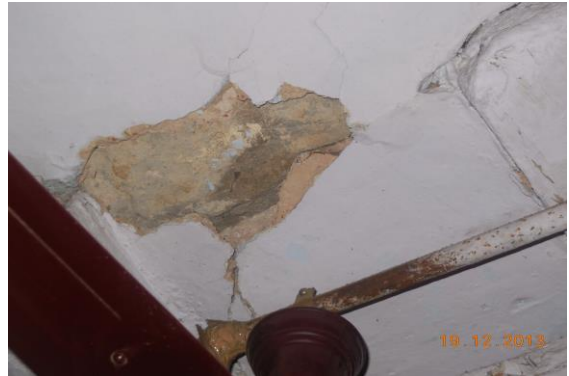
Photo 28
Damaged Portion on Roof of Varanda of First Floor

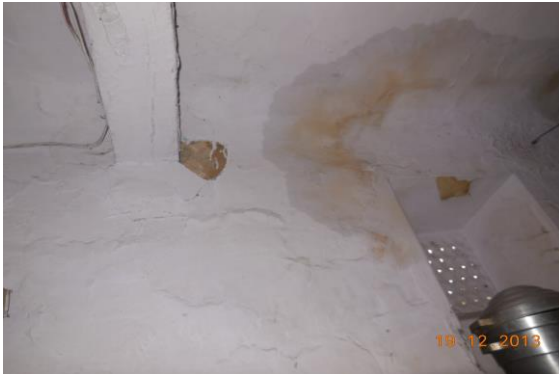
Photo 29
Damaged Portion on Wall No. 3 & Roof of Varanda of First Floor

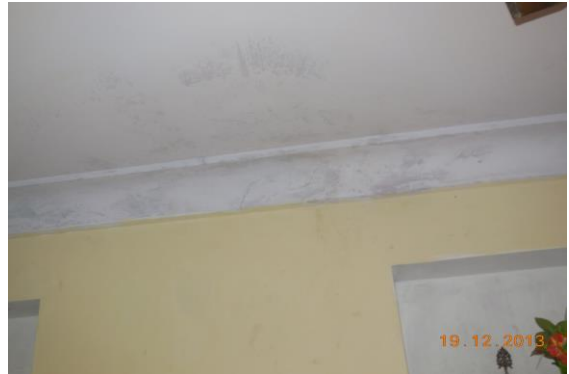
Photo 30
Dampness/Seepage on Wall No. 4 & Roof of Room No. 1 of First Floor

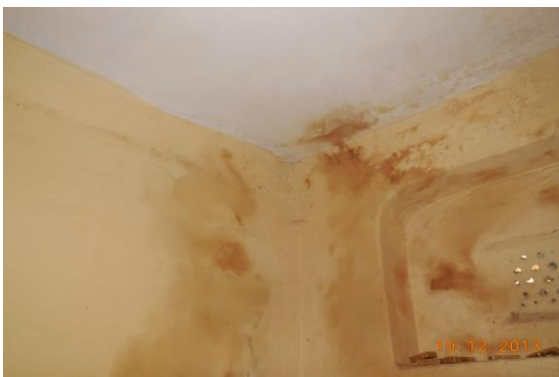
Photo 31
Dampness/Seepage on Wall No. 2, 4 & Roof of Toilet No. Toilet & Washroom of First Floor

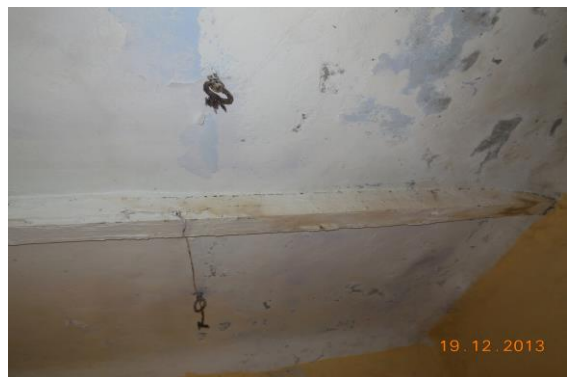
Photo 32
Dampness/Seepage on Roof of Kitchen of First Floor

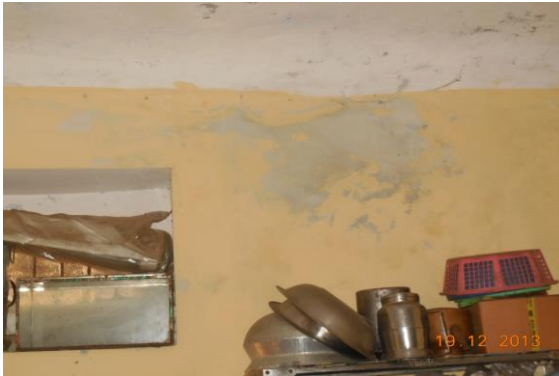
Photo 33
Peeling of Plaster on Wall No. 4 of Kitchen of First Floor

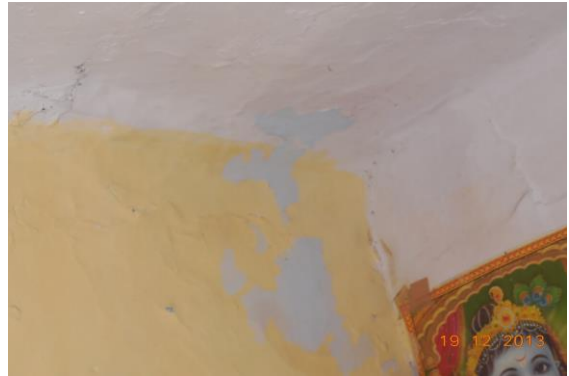
Photo 34
Peeling of Plaster on Wall No. 1 & Roof of Bilding Udey Singh Ji Ki Haveli of First Floor

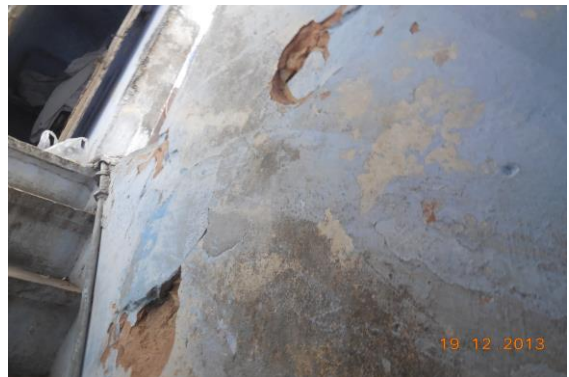
Photo 36
Peeling of Plaster on Wall No. 2 of Staircase First Floor To Second Floor of First Floor

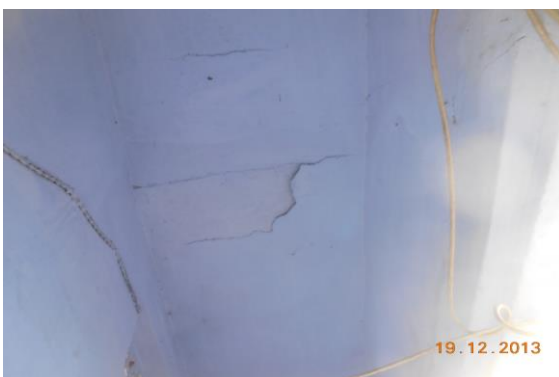
Photo 37
Peeling of Plaster on Roof of Bilding Udey Singh Ji Ki Haveli of First Floor

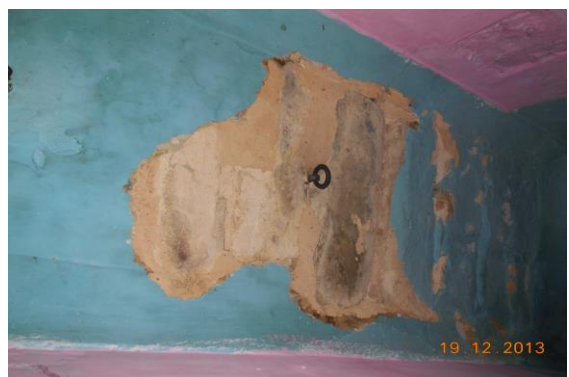
Photo 38
Damaged Portion on Roof of Kitchen of Second Floor

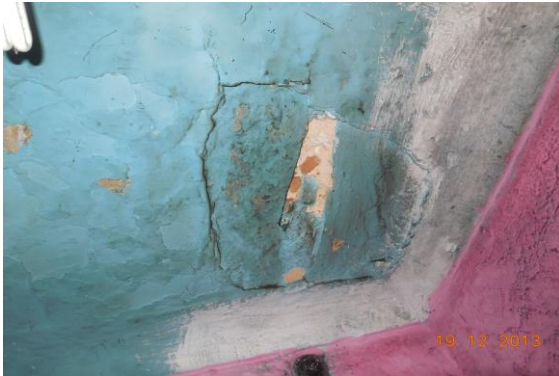
Photo 39
Damaged Portion on Roof of Kitchen of Second Floor

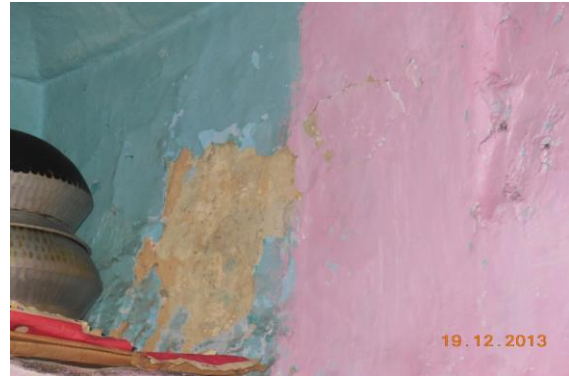
Photo 40
Peeling of Plaster on Wall No. 4 of Bilding Uday Singh Ji Ki Haveli of Second Floor

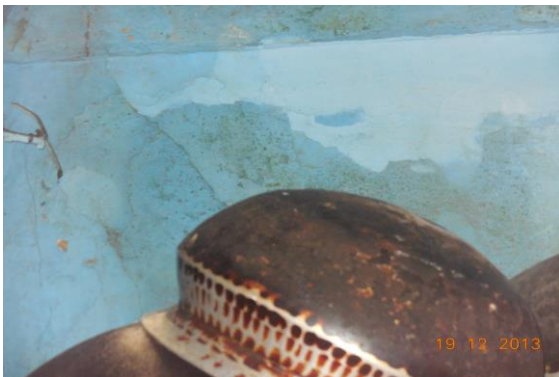
Photo 41
Dampness/Seepage on Wall No. 1 of Bilding Uday Singh Ji Ki Haveli of Second Floor

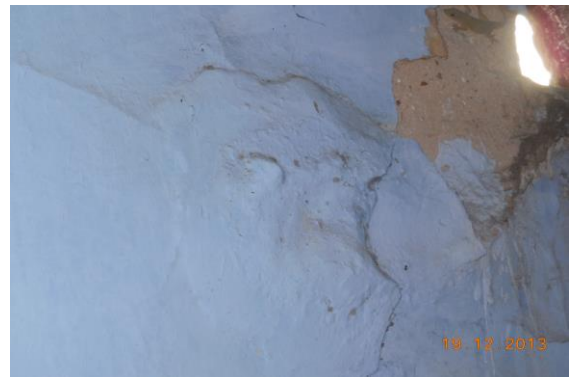
Photo 42
Peeling of Plaster on Wall No. 4 of Toilet & Washroom of Second Floor

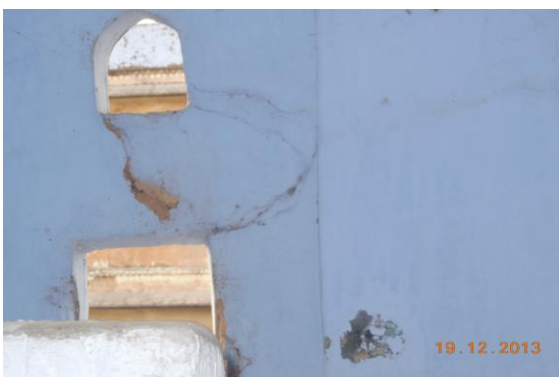
Photo 43
Peeling of Plaster on Wall No. 2 of Toilet & Washroom of Second Floor

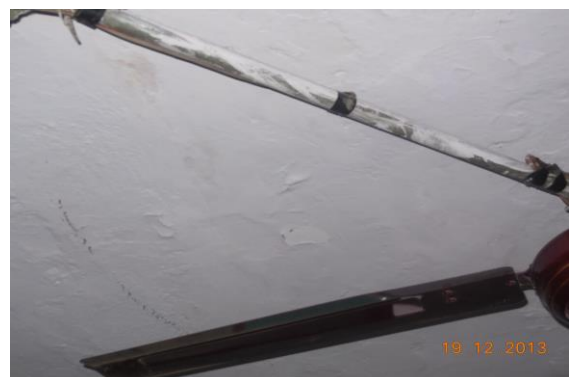
Photo 44
Peeling of Plaster on Roof of Room No. 1 of Second Floor

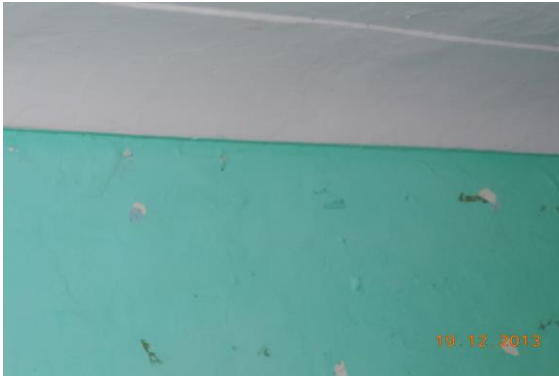
Photo 45

Peeling of Plaster on Wall No. 4 of Room No. 1 of Second Floor

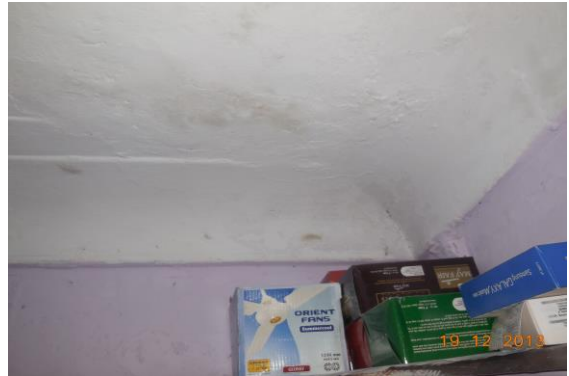
Photo 46

Dampness/Seepage on Roof of Room No. 2 of Second Floor

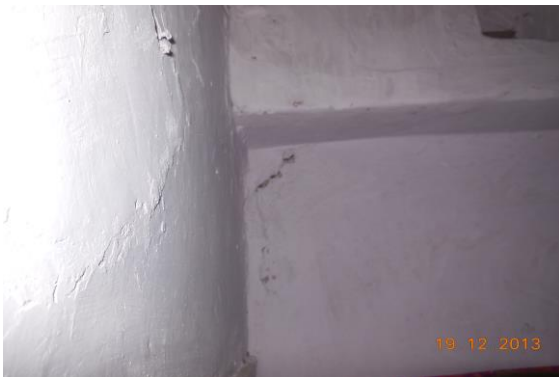
Photo 47

Peeling of Plaster on Wall No. 1 of Store of Second Floor

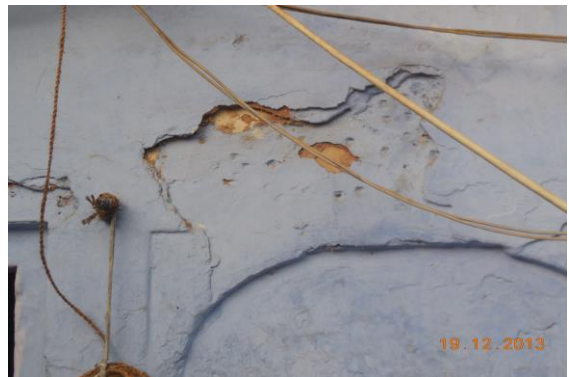
Photo 48

Peeling of Plaster on Wall No. 2 of Open Varanda No.1 of Second Floor

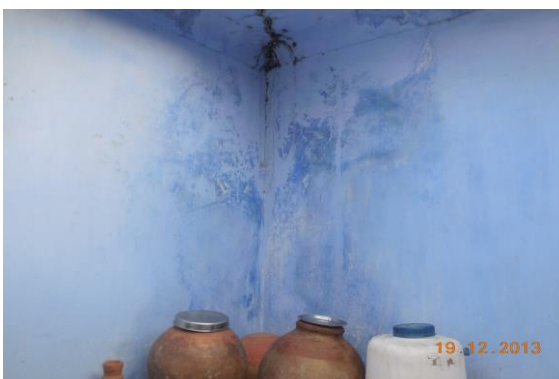
Photo 49

Dampness/Seepage on Wall No. 1 & 3 of Open Varanda No.1 of Second Floor

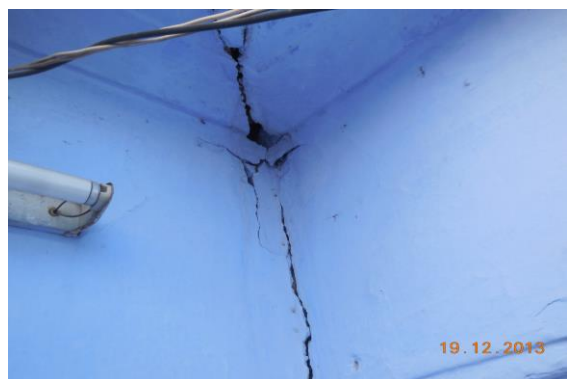
Photo 50

Peeling of Plaster on Wall No. 1 & 3 of Open Varanda No.1 of Second Floor

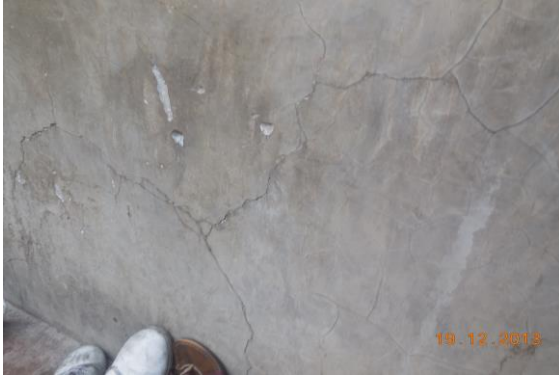
Photo 51

Plaster Crack on Wall No. 4 of Open Varanda No.1 of Second Floor

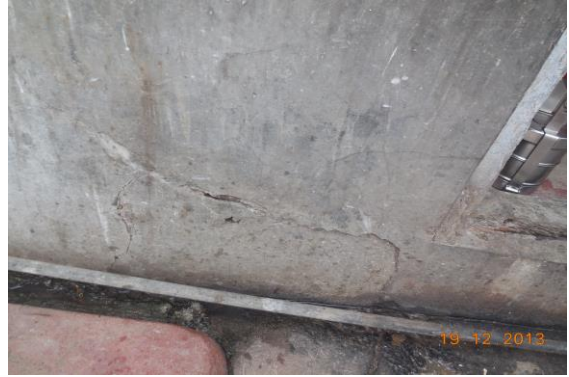
Photo 52

Peeling of Plaster on Wall No. 1 of Open Varanda No.1 of Second Floor

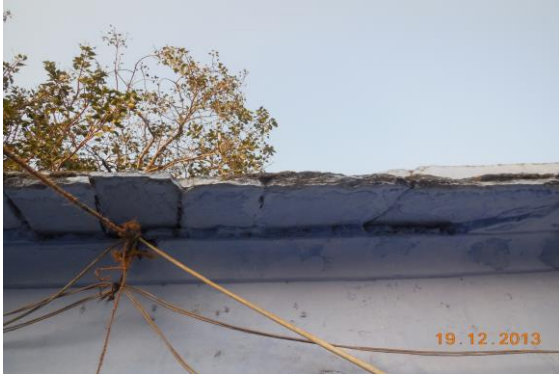
Photo 53

Damaged Portion on Sun Shade of Open Varanda No.1 of Second Floor

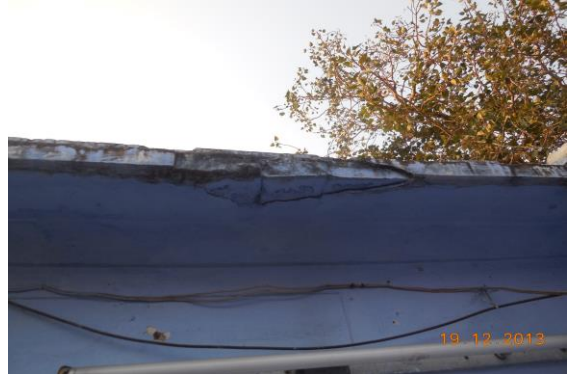
Photo 54

Damaged Portion on Sun Shade of Open Varanda No.1 of Second Floor

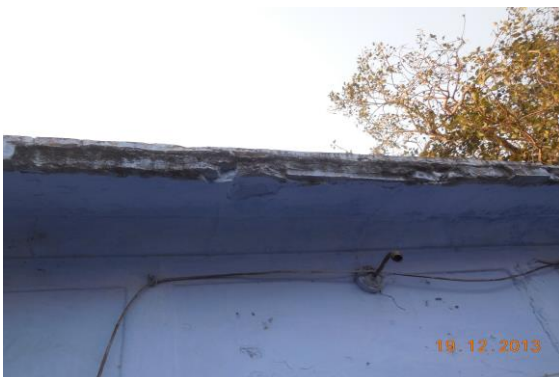
Photo 55

Damaged Portion on Sun Shade of Open Varanda No.1 of Second Floor

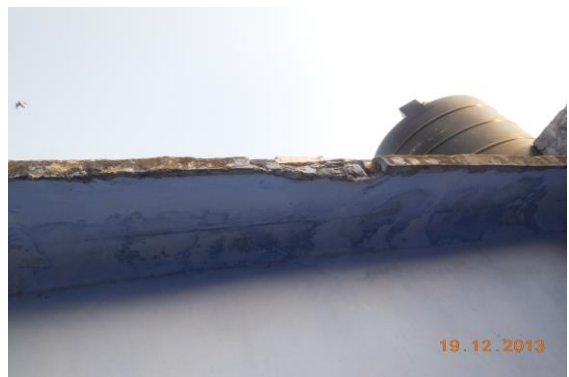
Photo 56

Damaged Portion on Sun Shade of Open Varanda No.1 of Second Floor

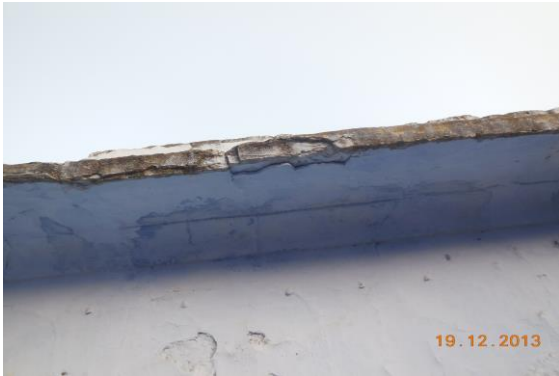
Photo 57

Damaged Portion on Sun Shade of Open Varanda No.1 of Second Floor

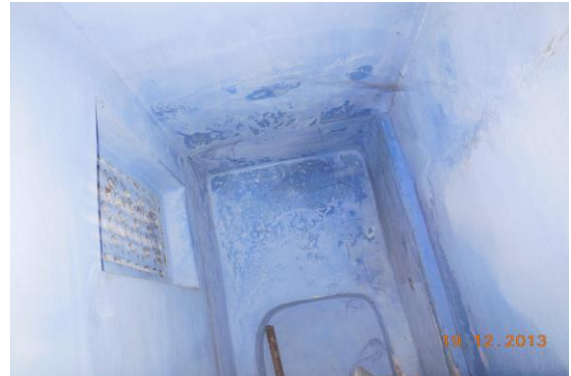
Photo 58

Dampness/Seepage on Wall No. 1, 2, 3 & Roof of Bathroom No. of Second Floor

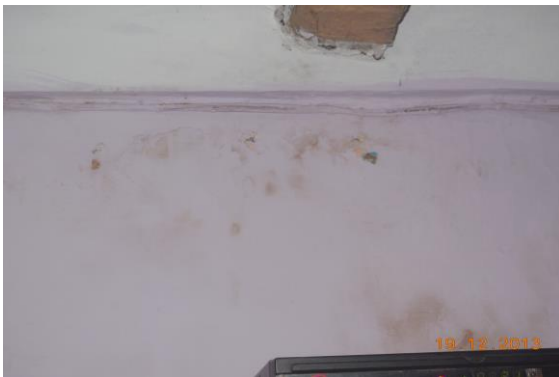
Photo 59

Peeling of Plaster on Wall No. 1 of Room No. 3 of Second Floor

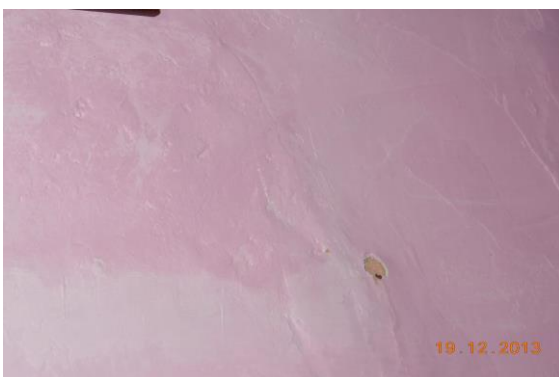
Photo 61

Peeling of Plaster on Wall No. 4 of Room No. 4 of Second Floor

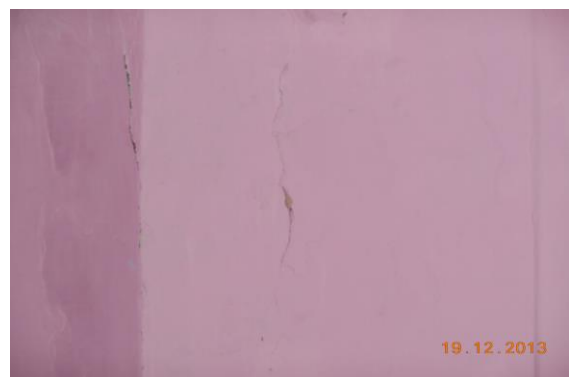
Photo 62

Plaster Crack on Wall No. 2 & 4 of Room No. 4 of Second Floor

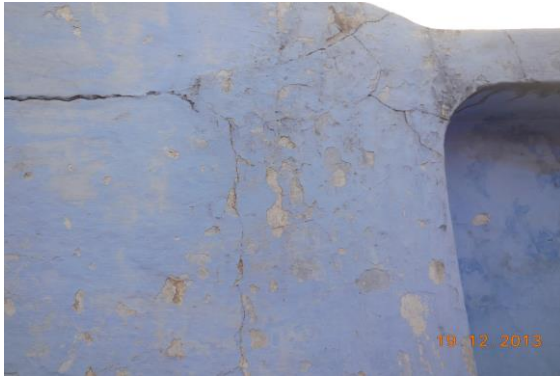
Photo 63

Plaster Crack on Wall No. 2 of Open Varanda No.2 of Second Floor

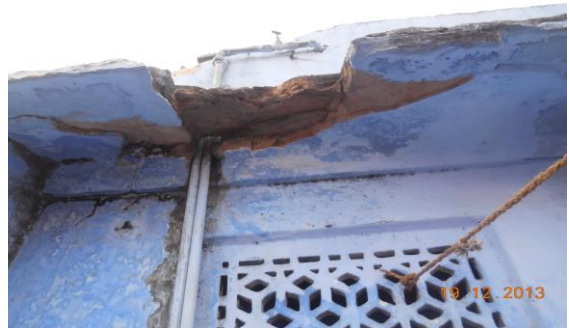
Photo 64

Damaged Portion on Sun Shade of Open Varanda No.2 of Second Floor

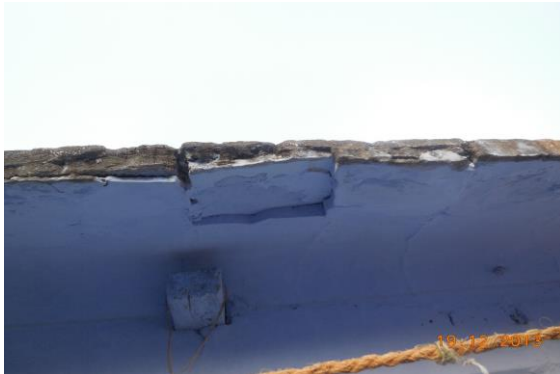
Photo 65

Damaged Portion on Sun Shade of Open Varanda No.2 of Second Floor

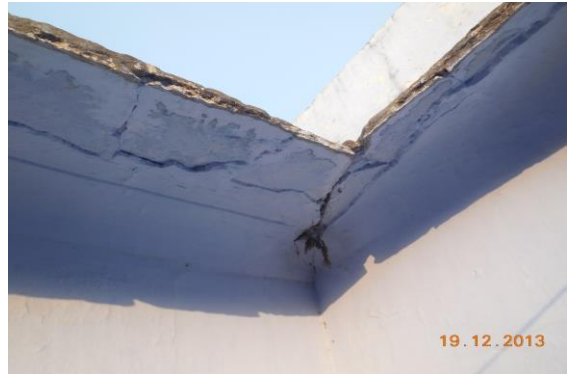
Photo 66

Damaged Portion on Sun Shade of Open Varanda No.2 of Second Floor

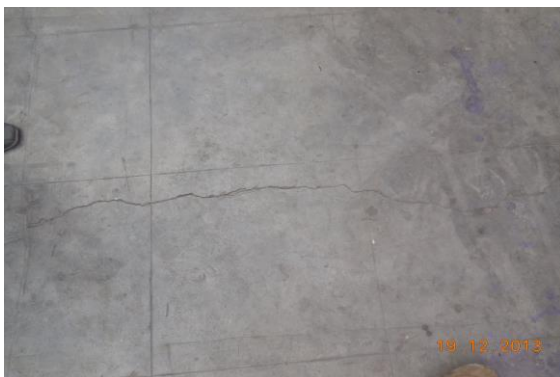
Photo 67

Plaster Crack on Floor of Open Varanda No.2 of Second Floor

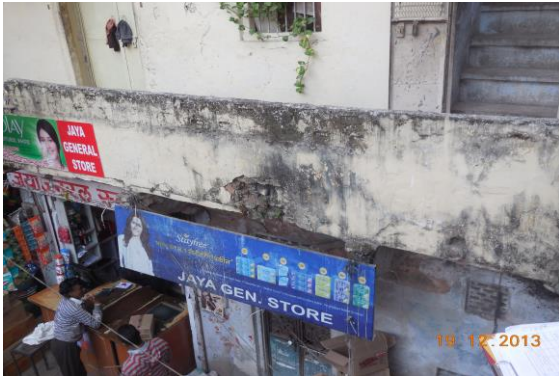
Photo 69

Damaged Portion on Perapet wall of Balcony of First Floor

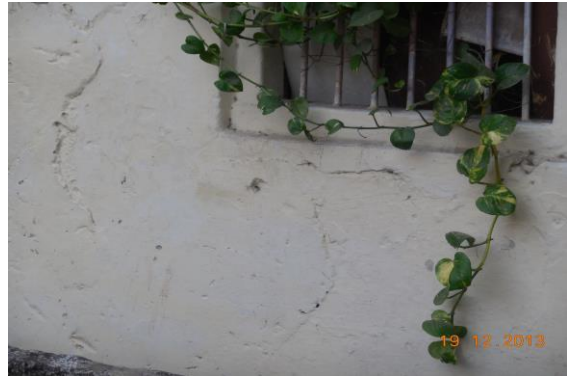
Photo 70

Peeling of Plaster on Wall No. 1 & Outside of Open Varanda No.1 of First Floor

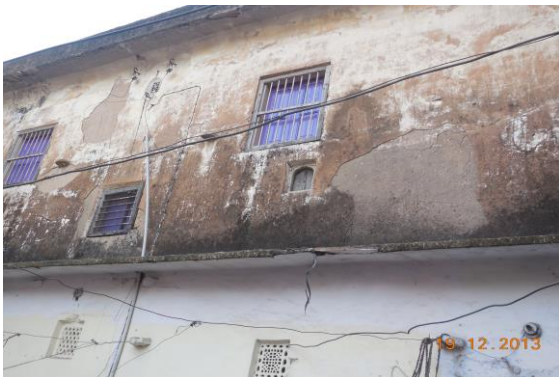
Photo 71

Damaged Portion on Outside of Open Varanda No.1 of First Floor

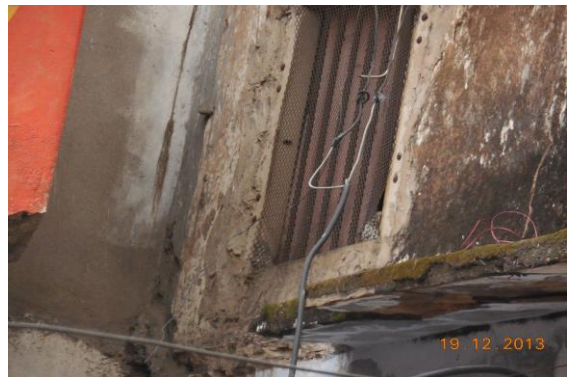
Photo 72

Damaged Portion on Outside of Open Varanda No.1 of Second Floor

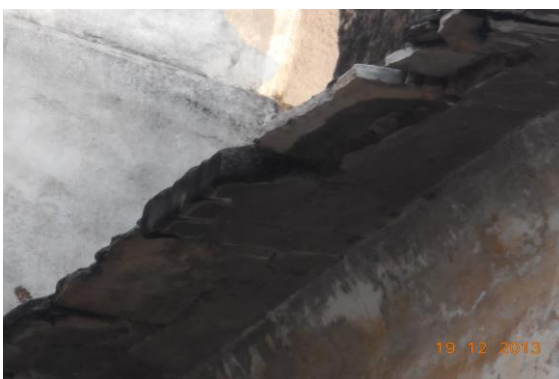
Photo 73

Damaged Portion on Sun Shade of Blding Udey Singh Ji Ki Haveli of Second Floor

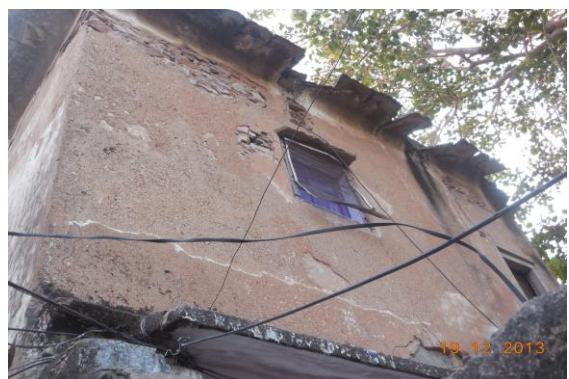
Photo 74

Damaged Portion on Outside of Blding Udey Singh Ji Ki Haveli of Second Floor

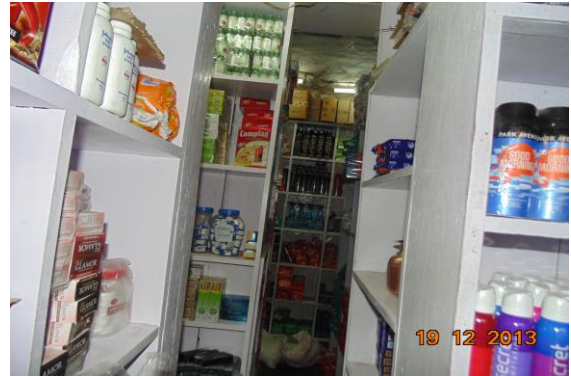
Photo 76

All walls of Shop Jaya General Store of Ground Floor Covered With Material

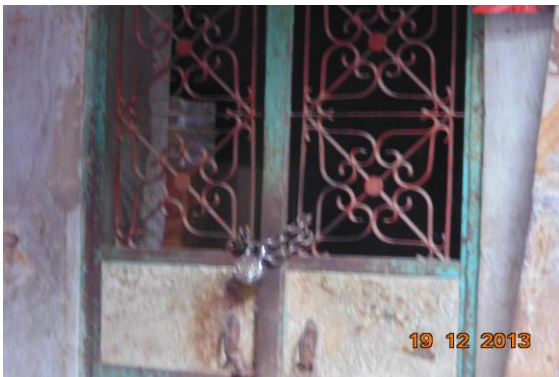
Photo 77

Shop of First Floor Locked

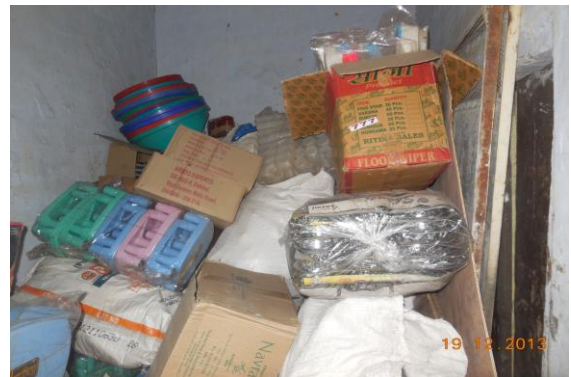
Photo 78

All Walls of Room No. 2 of First Floor Covered With Material

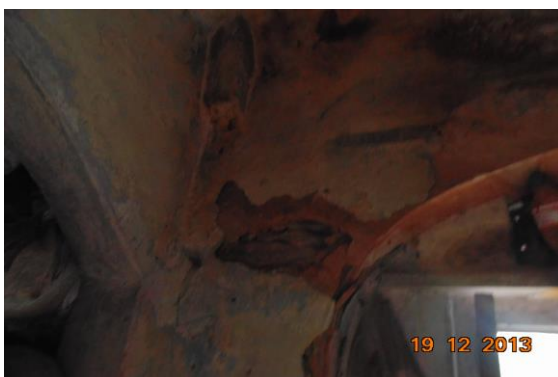
Photo 5

Peeling of Plaster on Wall No. 3 of Part A of Shop Lal Chand Jaya Chand of Ground Floor

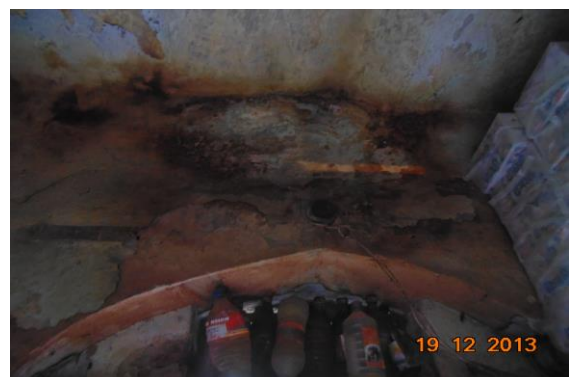
Photo 6

Dampness/Seepage on Wall No. 3 of Part A of Shop Lal Chand Jaya Chand of Ground Floor

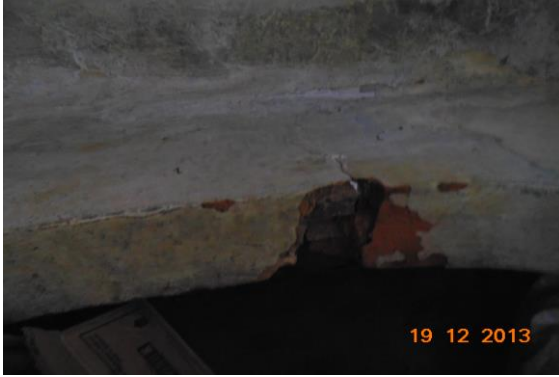
Photo 7

Damaged Portion on Roof of Part A of Shop Lal Chand Jaya Chand of Ground Floor

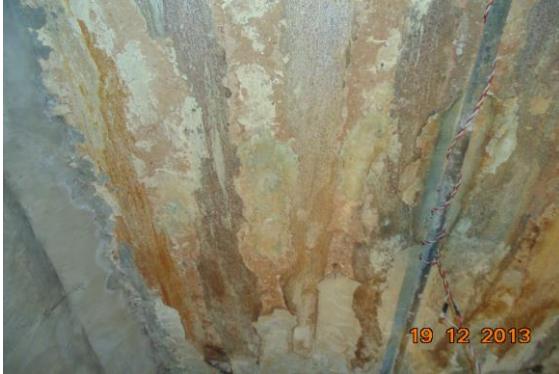
Photo 8

Peeling of Plaster on Wall No. 4 of Part A of Shop Lal Chand Jaya Chand of Ground Floor

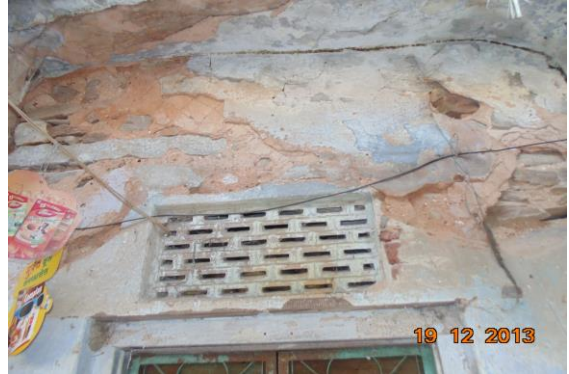
Photo 9

Peeling of Plaster on Roof of Shop Lal Chand Jaya Chand of Ground Floor

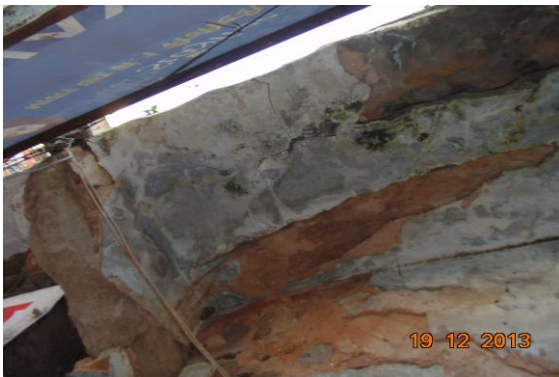
Photo 10

Damaged Portion on Outer Wall shade of Shop Lal Chand Jaya Chand of Ground Floor

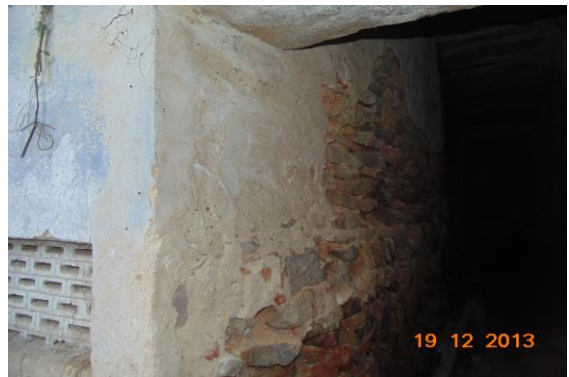
Photo 11

Damaged Portion on Outer Wall shade Roof of Shop Lal Chand Jaya Chand of Ground Floor

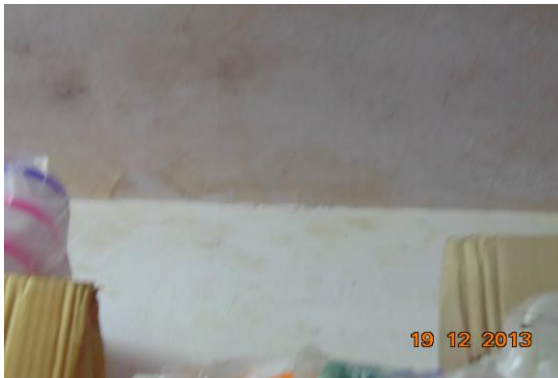
Photo 13

Dampness/Seepage on Wall No. 2 of Shop Mahaluxmi of Ground Floor

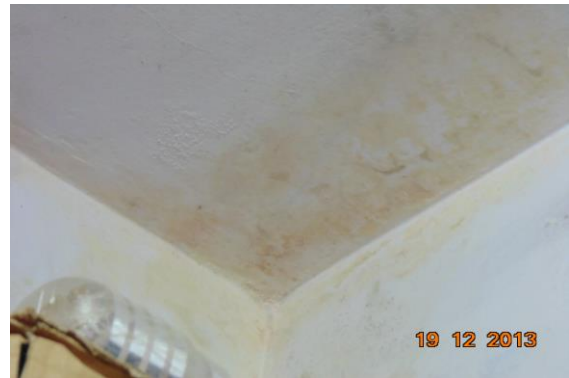
Photo 14

Dampness/Seepage on Roof of Shop Mahaluxmi of Ground Floor

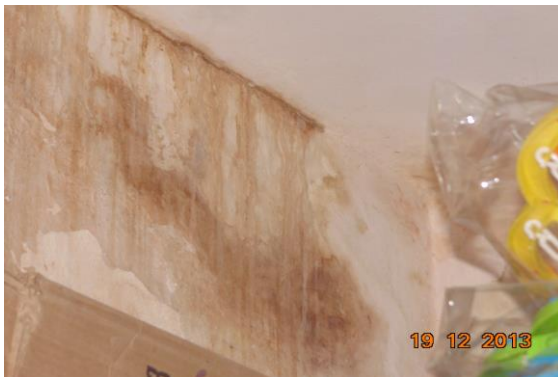
Photo 15

Dampness/Seepage on Wall No. 1 of Shop Mahaluxmi of Ground Floor

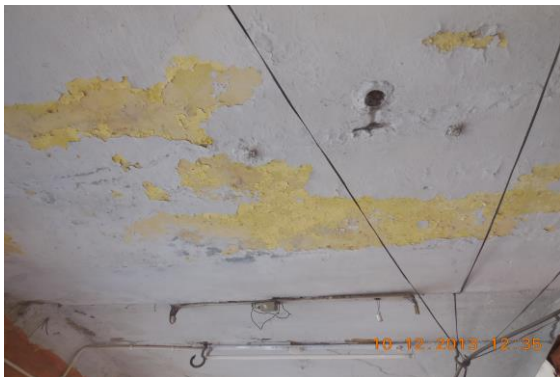
Summary of Defects Other Than Crack			
Defect ID	Location	Description	Photo No.
1	Roof Varanda of Shop no.363 Ground Floor	Dampness/Seepage	3
2	Roof Shop No.362 Ground Floor	Peeling of Plaster	4
3	Roof Shop No.362 Ground Floor	Peeling of Plaster	5

Photo 3
Dampness/Seepage on Roof of Varanda of Shop no.363 of Ground Floor

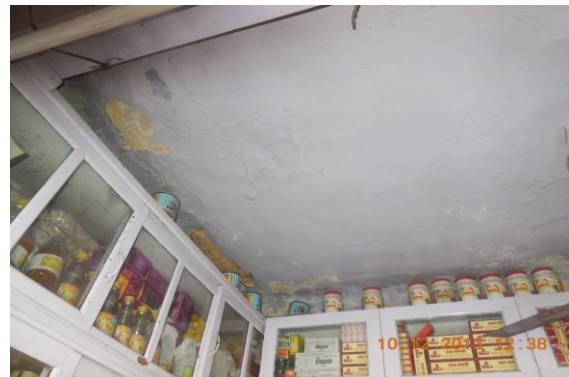
Photo 4
Peeling of Plaster on Roof of Shop No.362 of Ground Floor

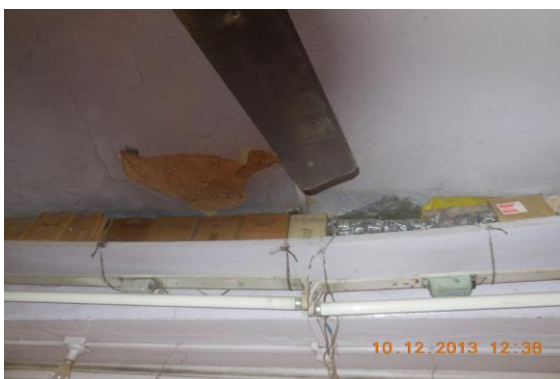
Photo 5
Peeling of Plaster on Roof of Shop No.362 of Ground Floor

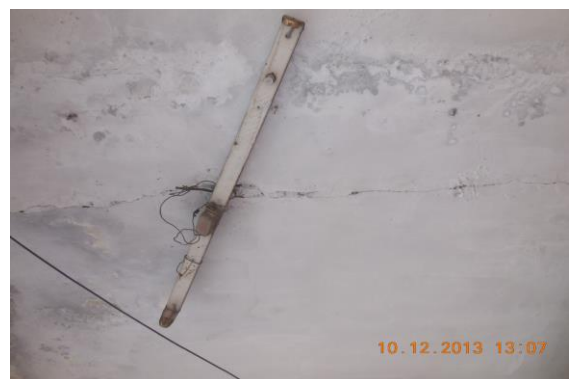
Summary of Cracks						
Defect ID	Location	Orientation	Appx. Width (mm)	Appx. Length (m)	Category	Photo No.
1	Roof Varanda of Shop No.359 Ground Floor	Horizontal	0.5	3	Very Slight	6
2	Roof Varanda of Shop No.360A Ground Floor	Horizontal	0.8	2	Very Slight	7

Photo 6
Horizontal Crack on Roof of Varanda of Shop No.359, Ground Floor, Approx. Width = 0.5mm, Approx. Length = 3m. Distance from Right side External Column = Backside, Height from Floor = 3m.

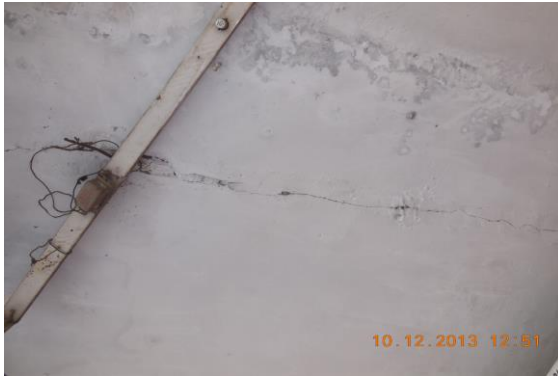
Photo 7

Horizontal Crack on Roof of Varanda of Shop No.360A, Ground Floor, Approx. Width = 0.8mm, Approx. Length = 2m. Distance from Left side External Column = Backside, Height from Floor = 3m.

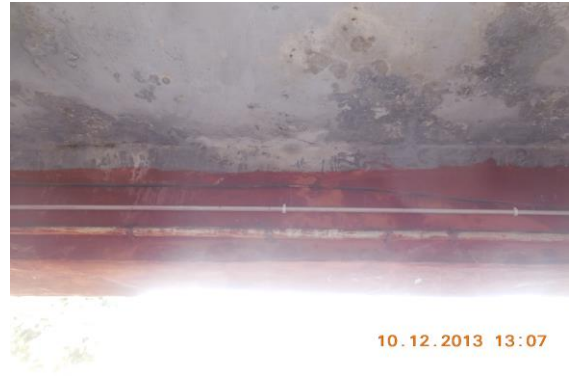
Photo 8

Dampness/Seepage on Roof of Varanda of Shop No.359 of Ground Floor

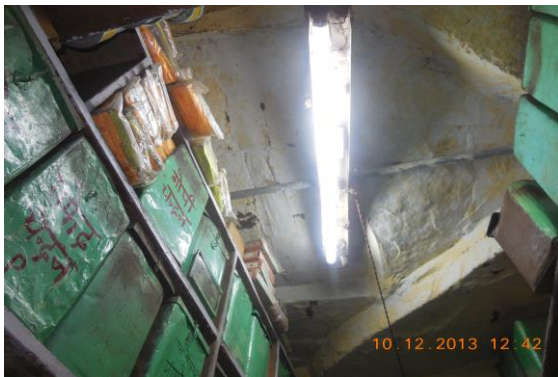
Photo 9

Peeling of Plaster on Roof of Shop No.361B of Ground Floor

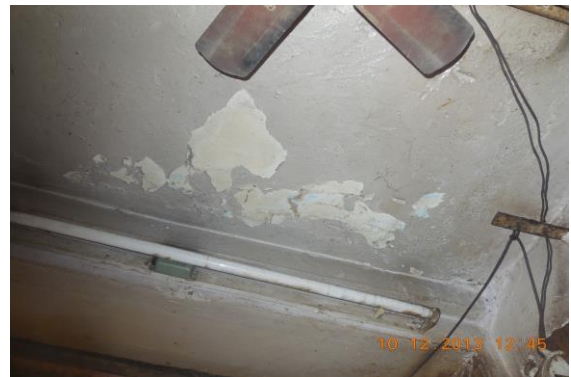
Photo 10

Peeling of Plaster on Roof of Shop No.361A of Ground Floor

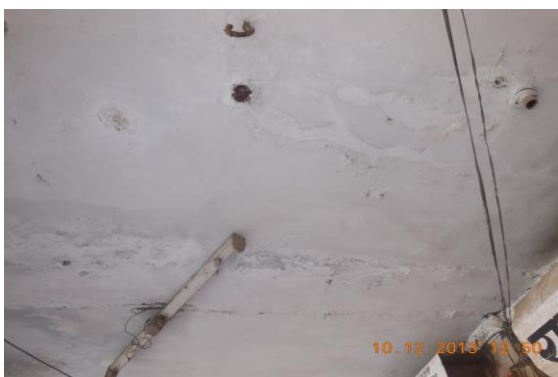
Photo 11

Dampness/Seepage on Roof of Varanda of Shop No.360A of Ground Floor

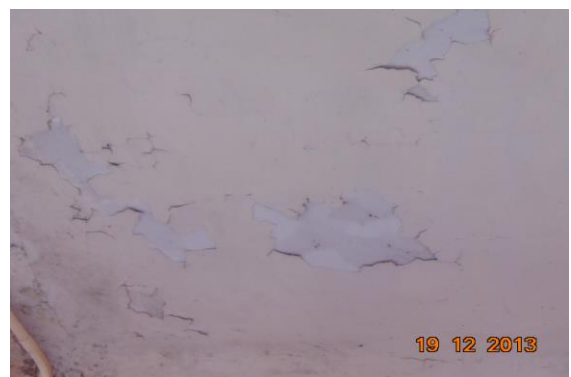
Photo 12

Peeling of Plaster on Roof of Shop No.360B of Ground Floor

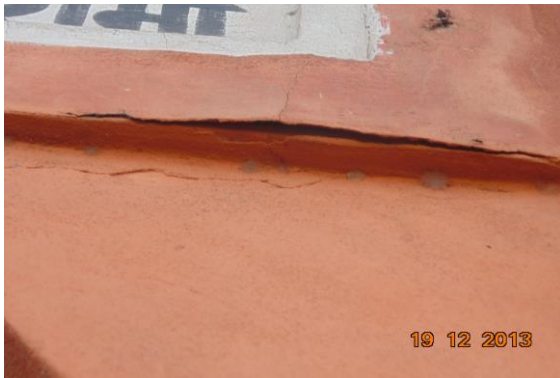
Photo 13

Plaster Crack on Outside Wall of Shop No.360B of Ground Floor

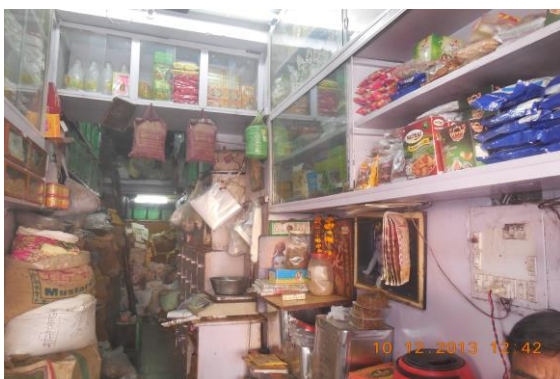
Photo 16

Wall No. 1 of Shop No.361B of Ground Floor Covered With material
