Pre Building Condition Survey Report

Name and Address of Structure :	Choti Chopar to Badi Chopar (Down Line)
---------------------------------	---

Name of the Project	Contract JMRC-UG1B “Design and Construction of Tunnel between Chandpole and Badi Chouper and reverse line by Shield TBM, Underground Metro Stations at Choti Chouper and Badi Chouper by Cut and Cover Methods on East West Corridor of Jaipur Metro Rail Corporation Limited .”	
Owner :

Pre Building Condition Survey Report Choti Chopar to Badi Chopar (Down Line)

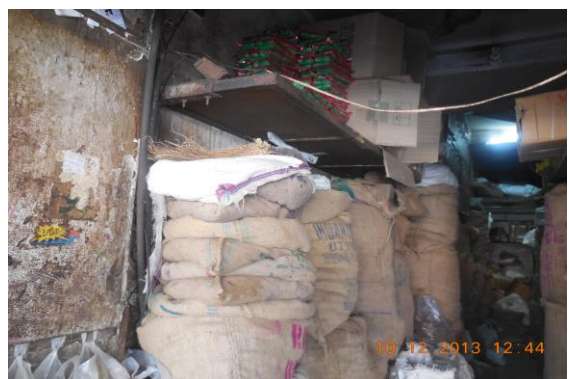
Photo 17

Wall No. 2 & 4 of Shop No.361B of Ground Floor Covered With material

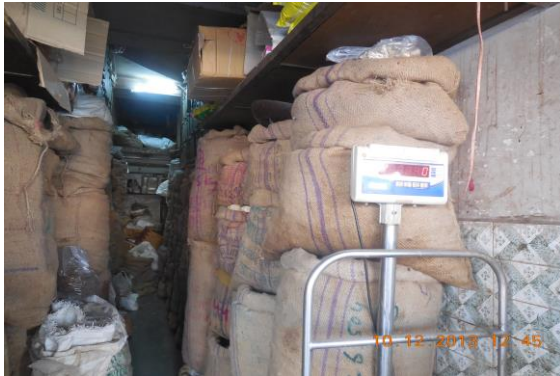
Photo 18

Wall No. 1 of Shop No.361A of Ground Floor Shop No.360A

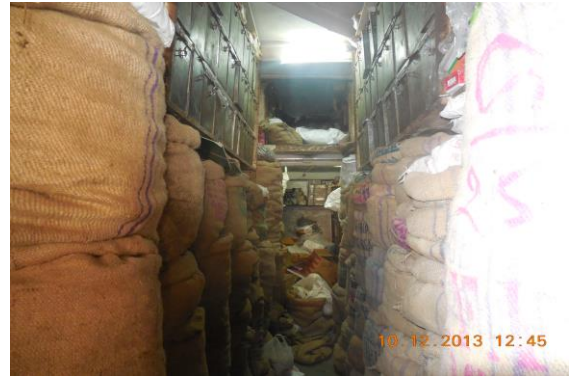
Photo 19

Wall No. 2 of Shop No.361A of Ground Floor Shop No.360A

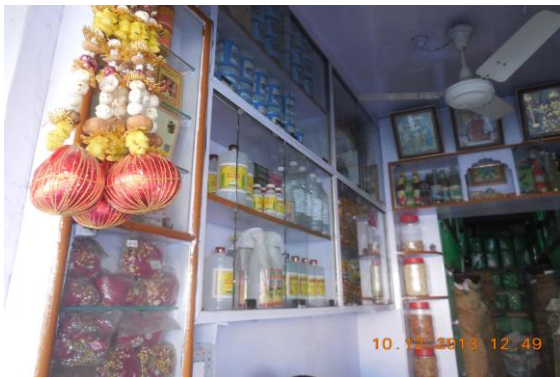
Photo 20

Wall No. 4 of Shop No.361A of Ground Floor Covered With material

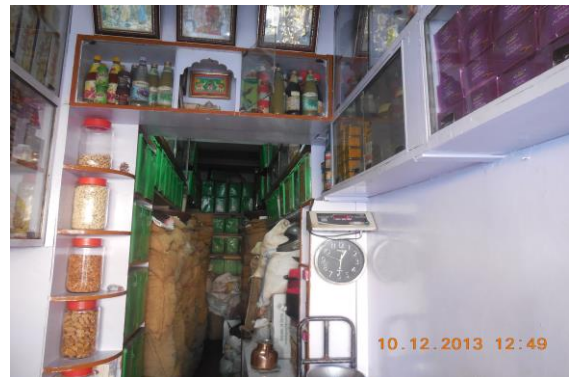
Photo 21

Wall No. 1 of Shop No.360A of Ground Floor Shop No.360A

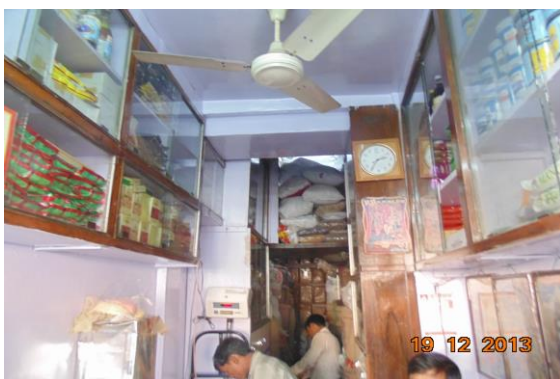
Photo 22

Wall No. 2 & 4 of Shop No.360A of Ground Floor Shop No.360A

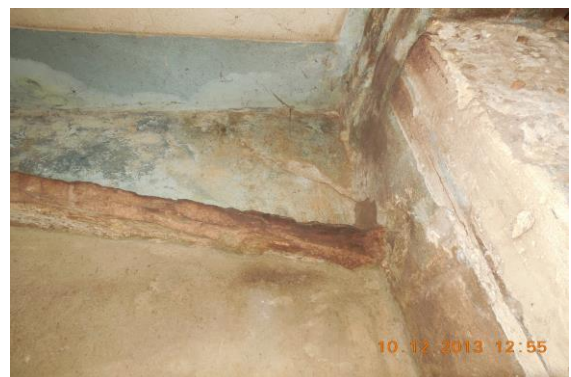
Photo 6
Inclined Crack on Wall No. 2 of Part A of Shop No.357, Ground Floor
Approx. Width = 0.6mm, Approx. Length = 0.7m.
Distance from Wall no.3 = 0m, Height from Floor = 2.5m.

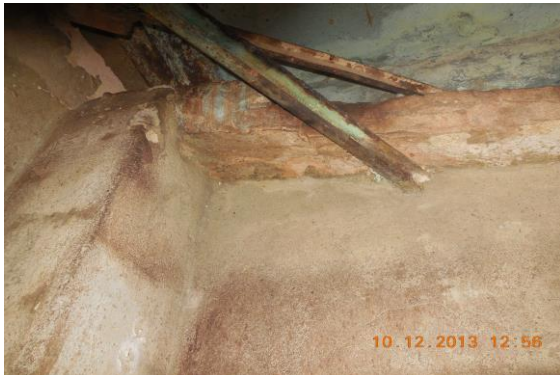
Photo 7

Inclined Crack on Wall No. 2 of Part A of Shop No.357, Ground Floor
Approx. Width = 0.5mm, Approx. Length = 0.5m.
Distance from Wall no.4 = 0.8m, Height from Floor = 2.5m.

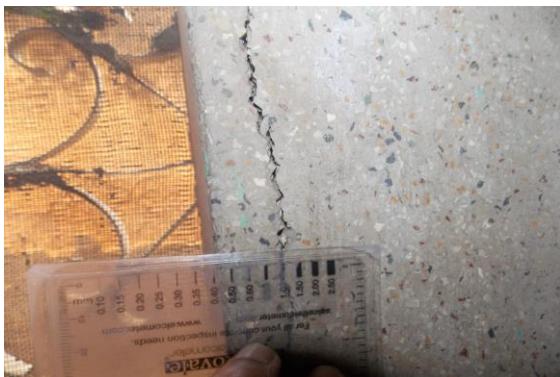
Photo 9A

Vertical Crack on Wall No. 2 of Staircase, House Above Shop No.355 to 358, First Floor
Approx. Width = 1mm, Approx. Length = 2m.
Distance from = m Height from Floor = m

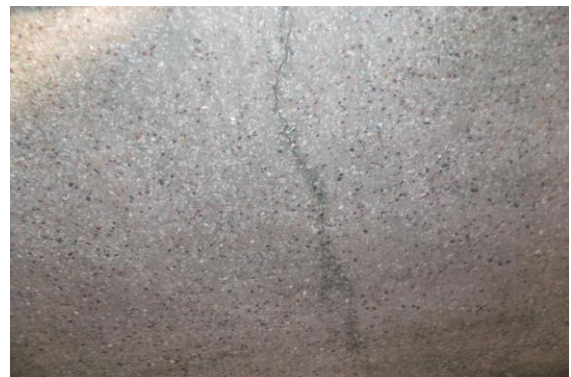
Photo 9

Inclined Crack on Wall No. 4 of Room No. 2, House Above Shop No.355 to 358, Second Floor
Approx. Width = 0.8mm, Approx. Length = 0.5m.
Distance from Wall No 1 = 2.5m Height from Floor = 0m

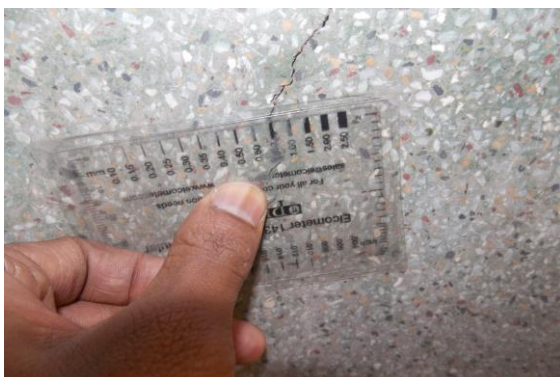
Photo 9A

Inclined Crack on Wall No. 4 of Room No. 2, House Above Shop No.355 to 358, Second Floor
Approx. Width = 0.8mm, Approx. Length = 0.5m.
Distance from Wall No. 1 = 2.5m Height from Floor = 0m

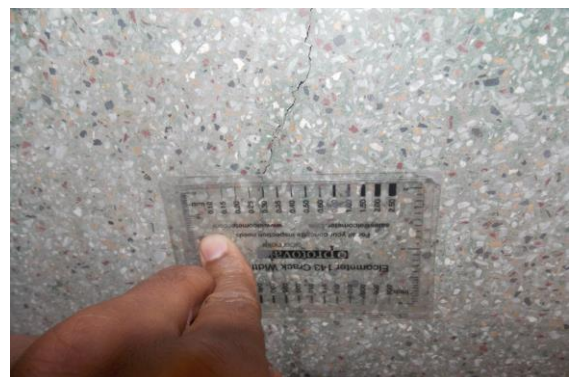
Photo 10

Inclined Crack on Wall No. 4 of Room No. 2, House Above Shop No.355 to 358, Second Floor
Approx. Width = 0.3mm, Approx. Length = 0.5m.
Distance from Wall No. 1 = 1.2m Height from Floor = 0m

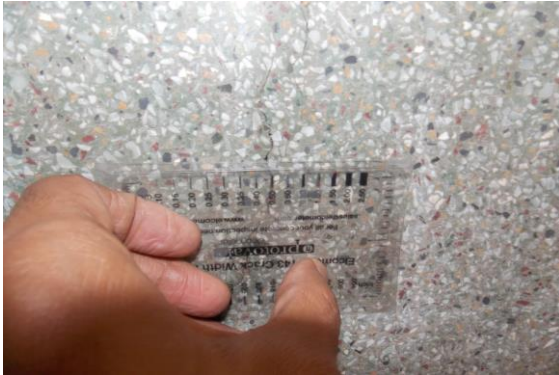
PHOTO 10A

Inclined Crack on Wall No. 4 of Room No. 2, House Above Shop No.355 to 358, Second Floor

Approx. Width = 0.3mm, Approx. Length = 0.5m.
Distance from Wall No 1 = 1.2m Height from Floor = 0m

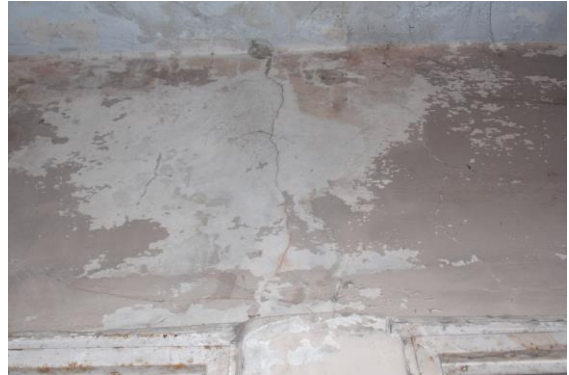
PHOTO 11

Inclined Crack on Wall No. 4 of Balcony, House Above Shop No.355 to 358, Second Floor

Approx. Width = 0.5mm, Approx. Length = 0.8m.
Distance from Wall No 1 = 0.8m Height from Floor = 2.3m

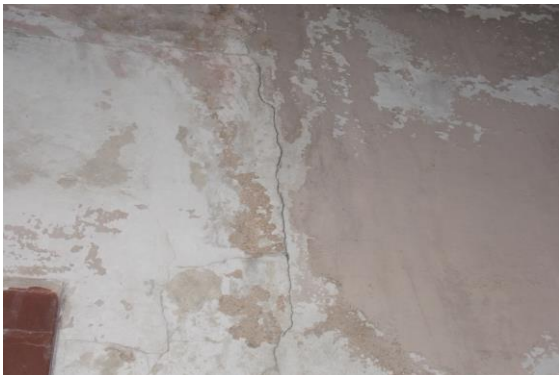
PHOTO 12

Vertical Crack on Wall No. 3 of Balcony, House Above Shop No.355 to 358, Second Floor

Approx. Width = 0.5mm, Approx. Length = 1m.
Distance from Wall No 1 = 0.8m Height from Floor = 2.2m

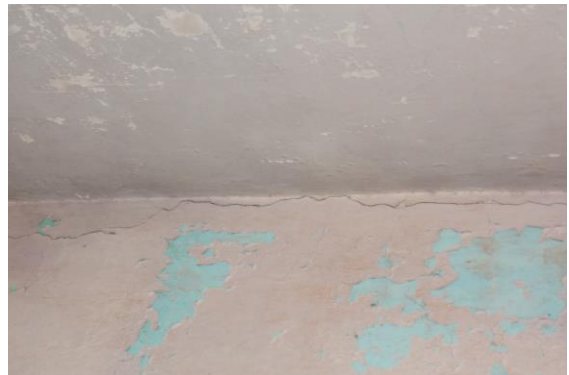
Photo 13

Horizontal Crack on Wall No. 4 of Staircase, Terrace

Approx. Width = 1mm, Approx. Length = 1.3m.
Distance from Wall No. 2 = 0.6m, Height from Floor = 2.1m.

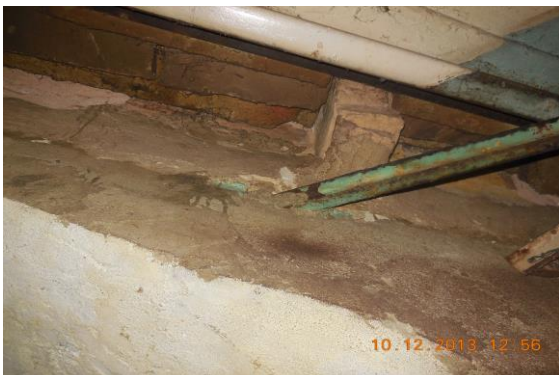
Photo 14

Damaged Portion on Roof of Part A of Shop No.357 of Ground Floor

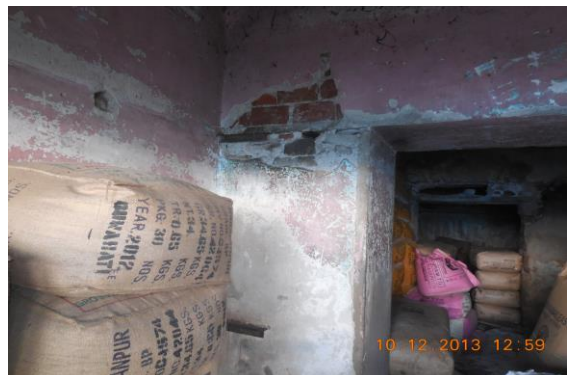
Photo 15

Peeling of Plaster on Wall No. 4 of Part A of Shop No.358 of Ground Floor

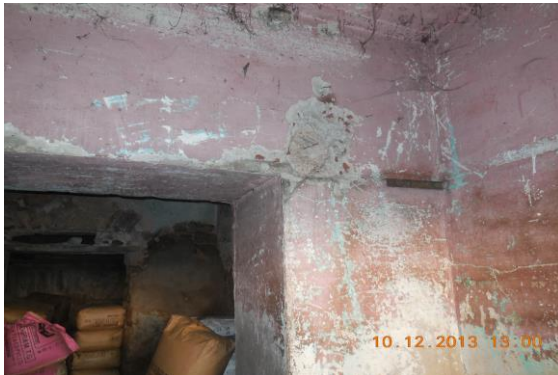
Photo 16

Peeling of Plaster on Wall No. 4 of Part A of Shop No.358 of Ground Floor

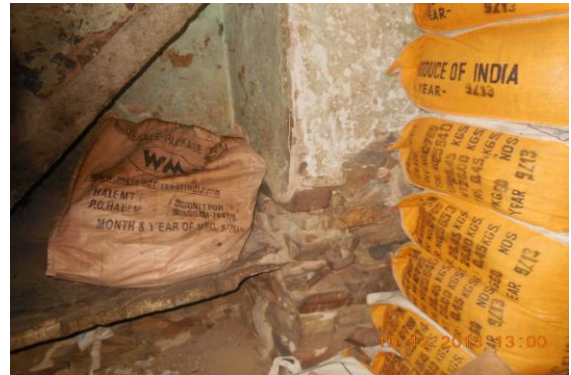
Photo 17

Peeling of Plaster on Wall No. 1 of Part B of Shop No.358 of Ground Floor

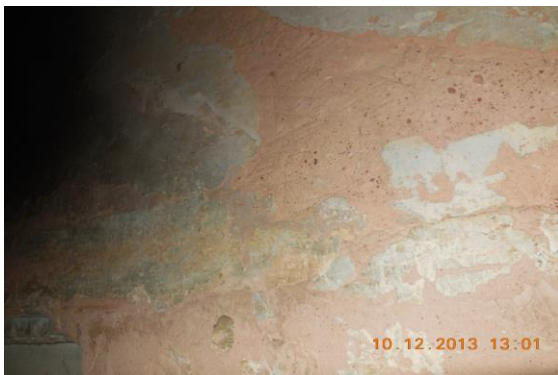
Photo 18

Peeling of Plaster on Wall No. 2 of Part B of Shop No.358 of Ground Floor

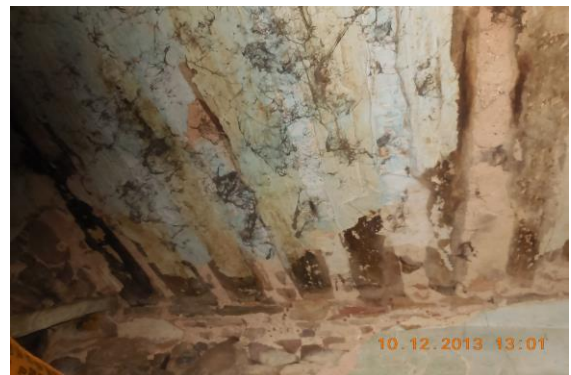
Photo 19

Peeling of Plaster on Roof of Part B of Shop No.358 of Ground Floor

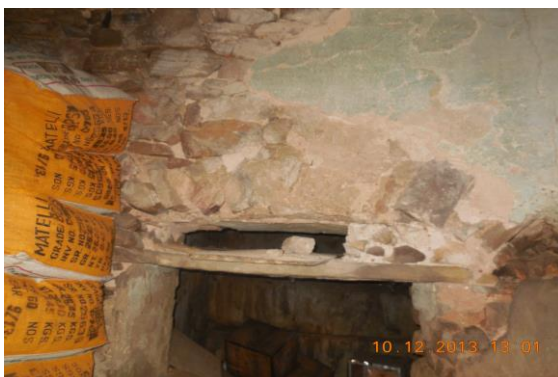
Photo 20

Damaged Portion on Wall No. 4 of Part B of Shop No.358 of Ground Floor

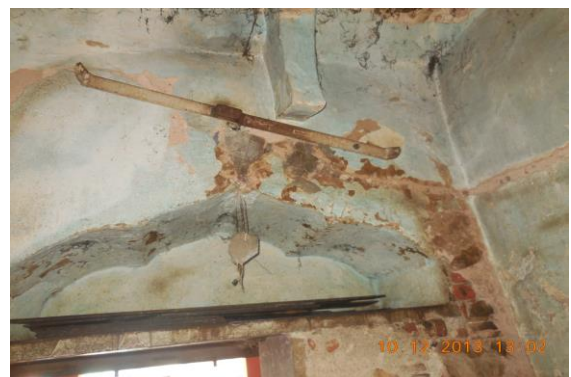
Photo 21

Peeling of Plaster on Wall No. 3 of Part B of Shop No.358 of Ground Floor

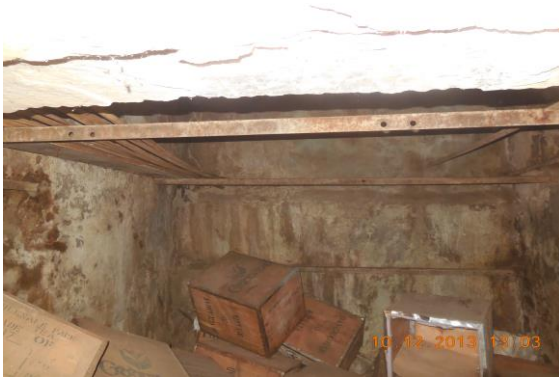
Photo 22

Dampness/Seepage on Wall No. 4 of Part C of Shop No.358 of Ground Floor

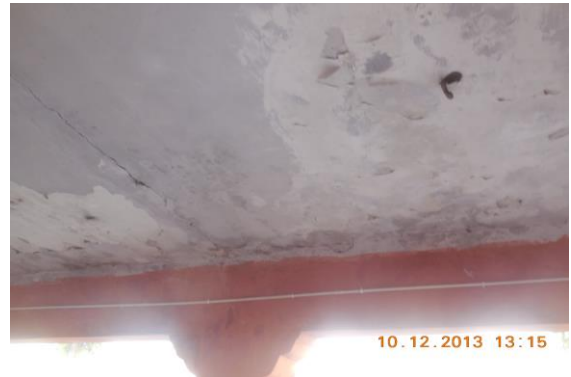
Photo 23

Dampness/Seepage on Roof of Varanda of Shop No.356 of Ground Floor

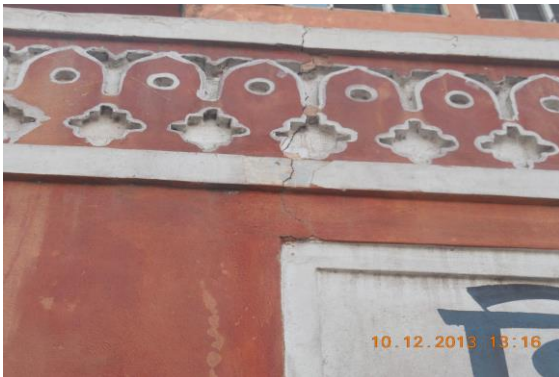
Photo 24

Peeling of Plaster on External Rightside Column of Varanda of Shop No.356 of Ground Floor

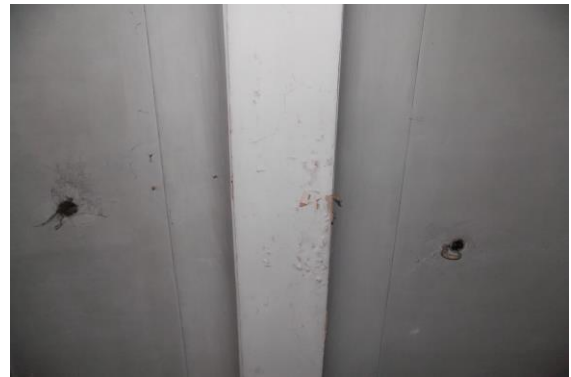
Photo 25

Peeling of Plaster on Roof of Room No. 1 of House Above Shop No.355 to 358, First Floor

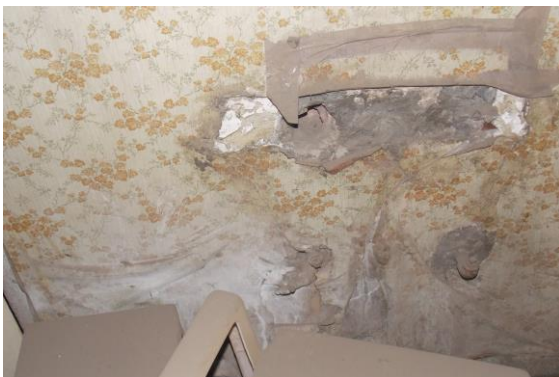
Photo 26

Peeling of Plaster on Wall No. 3 of Room No. 1 of House Above Shop No.355 to 358, First Floor

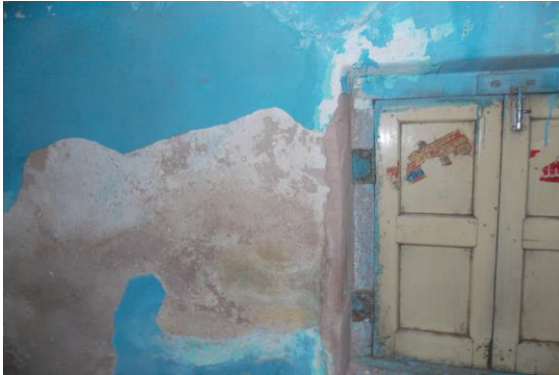
Photo 28

Peeling of Plaster on Wall No. 4 of Room No. 3 of House Above Shop No.355 to 358, First Floor

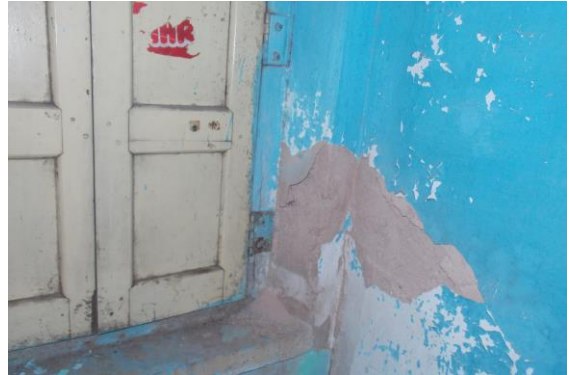
Photo 29

Damaged Portion on Wall No. 2 of Room No. 3 of House Above Shop No.355 to 358, First Floor

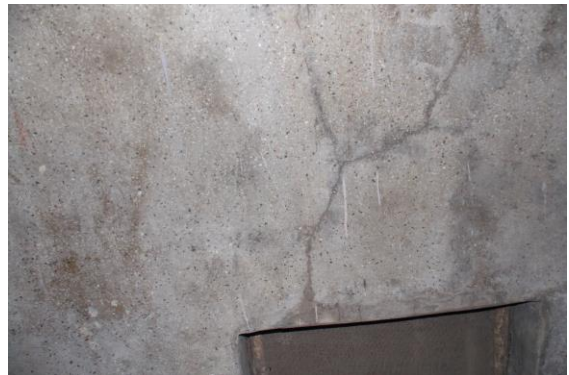
Photo 30

Peeling of Plaster on Wall No. 3 of Room No. 3 of House Above Shop No.355 to 358, First Floor

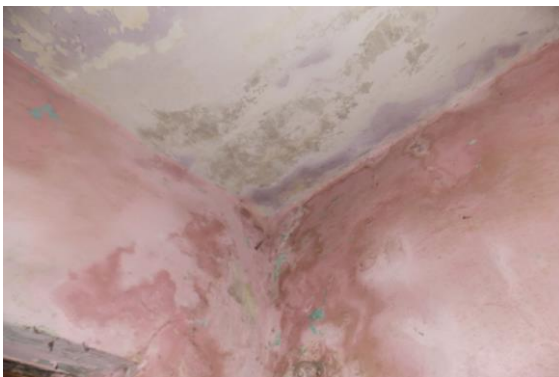
Photo 31

Peeling of Plaster on Wall No. 2 of Staircase of House Above Shop No.355 to 358, First Floor

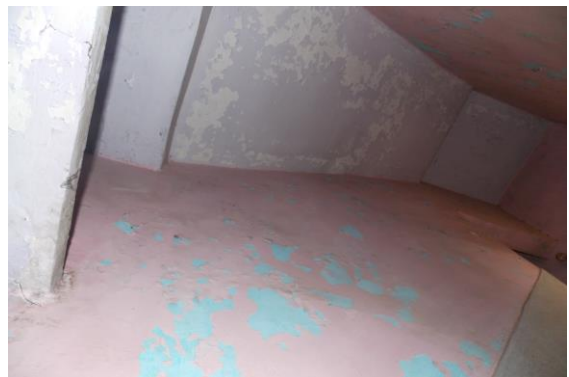
Photo 32

Dampness/Seepage on Wall No. 2, 3 & Roof of Staircase of House Above Shop No.355 to 358, First Floor

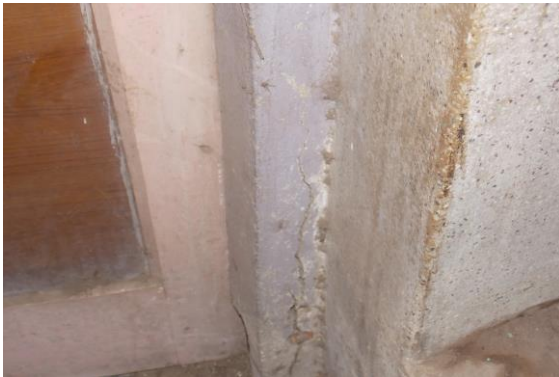
Photo 33

Peeling of Plaster on Wall No. 1 & Roof of Staircase of House Above Shop No.355 to 358, First Floor

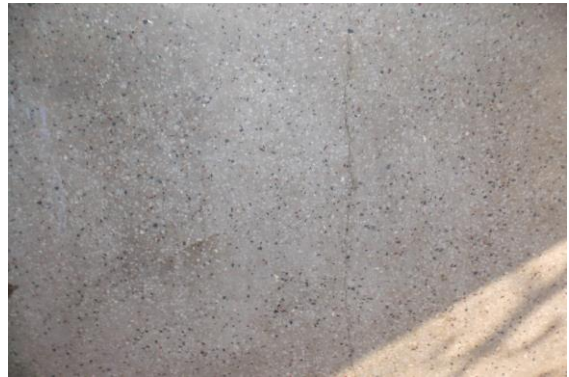
Photo 34

Damaged Portion on Wall No. Rightside Outer Wall of Bathroom of House Above Shop No.355 to 358, First Floor

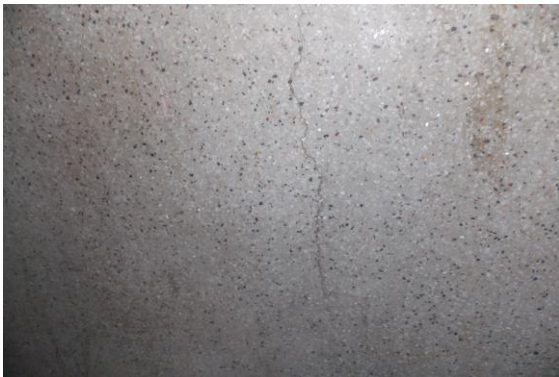
Photo 35

Peeling of Plaster on Wall No. 3 of Staircase of House Above Shop No.355 to 358, Second Floor

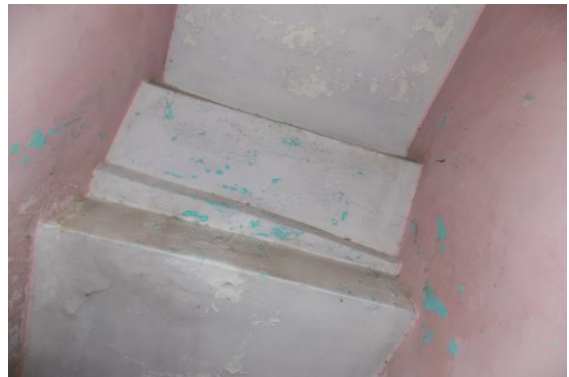
Photo 36

Peeling of Plaster on Wall No. 2 of House Above Shop No.355 to 358 of House Above Shop No.355 to 358, Second Floor

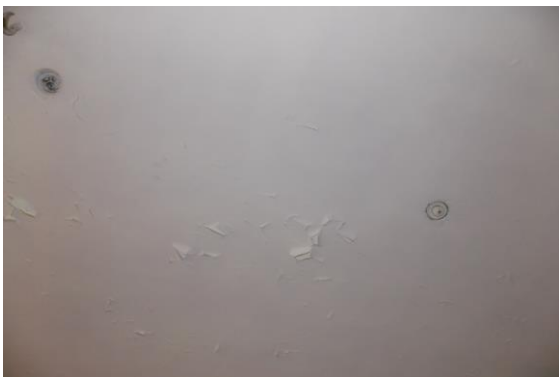
Photo 37

Peeling of Plaster on Roof of House Above Shop No.355 to 358 of House Above Shop No.355 to 358, Second Floor

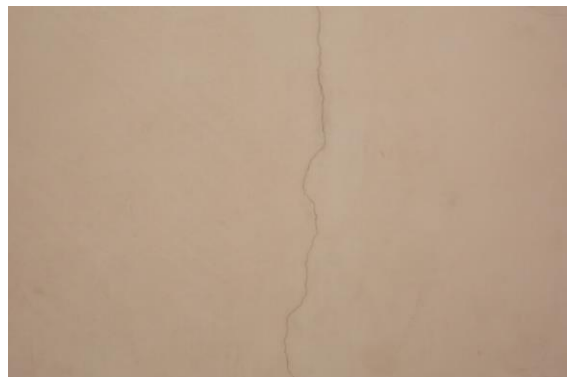
Photo 38

Peeling of Plaster on Roof of Room No. 2 of House Above Shop No.355 to 358, Second Floor

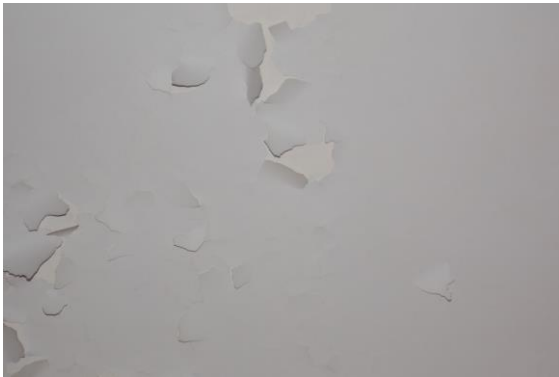
Photo 39

Peeling of Plaster on Wall No. 4 of Room No. 3 of House Above Shop No.355 to 358, Second Floor

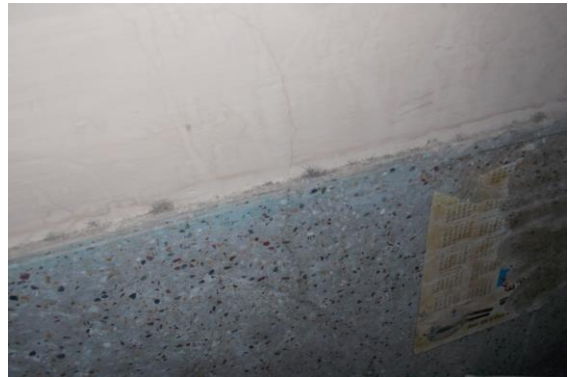
Photo 40

Peeling of Plaster on Roof of Room No. 3 of House Above Shop No.355 to 358, Second Floor

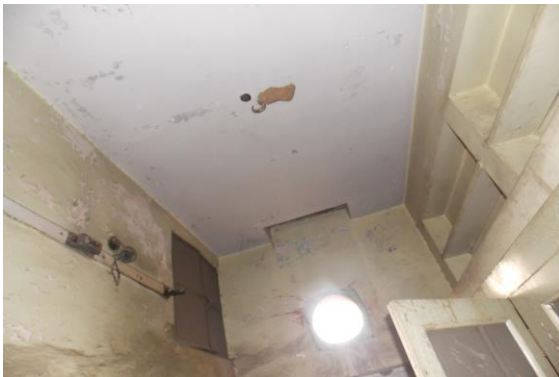
Photo 41

Peeling of Plaster on Wall No. 3 of Room No. 3 of House Above Shop No.355 to 358, Second Floor

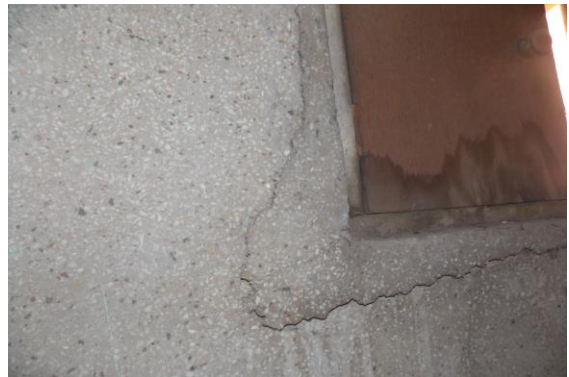
Photo 42

Peeling of Plaster on All Walls & Roof of Kitchen of House Above Shop No.355 to 358, Second Floor

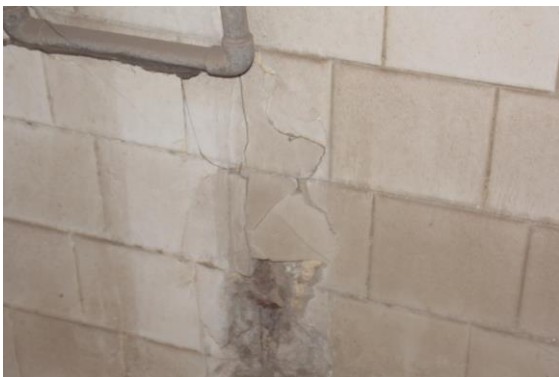
Photo 43

Damaged Portion on Wall No. 4 of Passage of House Above Shop No.355 to 358, Second Floor

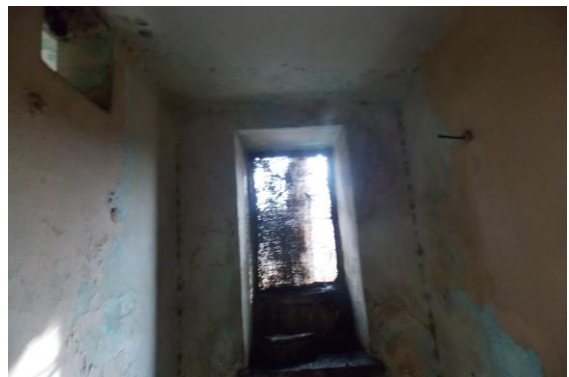
Photo 44

Damaged Portion on Wall No. 4 of Bathroom of House Above Shop No.355 to 358, Second Floor

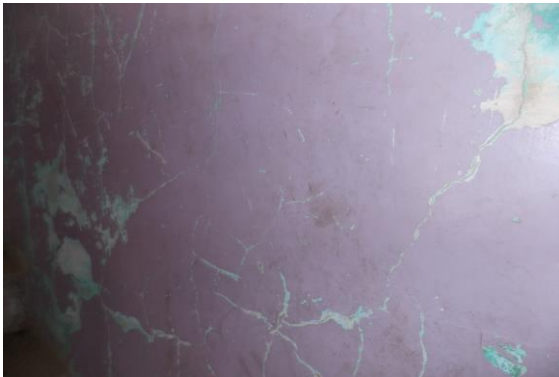
Photo 45

Dampness/Seepage on All Walls & Roof of Bathroom of House Above Shop No.355 to 358, Second Floor

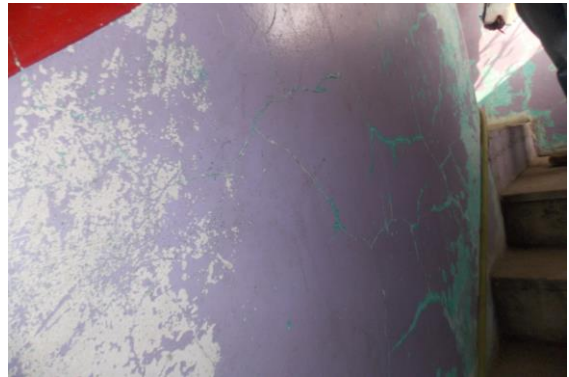
Photo 46

Peeling of Plaster on Wall No. 2 of Staircase Second Floor To Third Floor of House Above Shop No.355 to 358, Second Floor

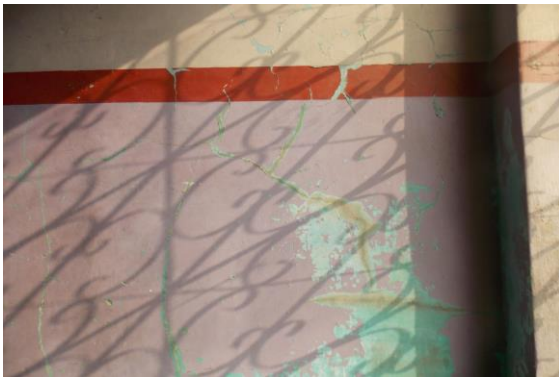
Photo 47

Peeling of Plaster on Wall No. 1 of Staircase Second Floor To Third Floor of House Above Shop No.355 to 358, Second Floor

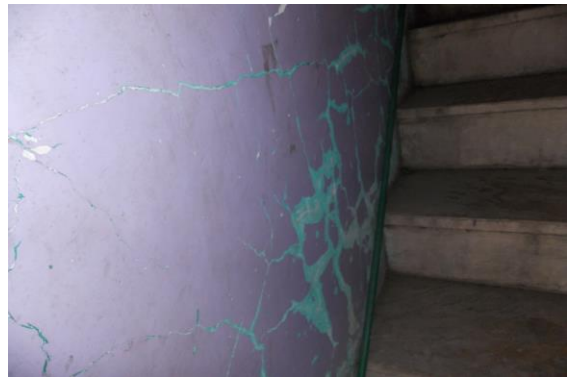
Photo 48

Peeling of Plaster on Wall No. 4 of Staircase Second Floor To Third Floor of House Above Shop No.355 to 358, Second Floor

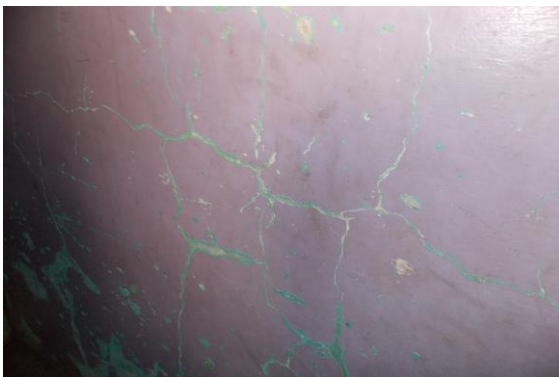
Photo 49

Peeling of Plaster on Wall No. 1 of Staircase Second Floor To Third Floor of House Above Shop No.355 to 358, Second Floor

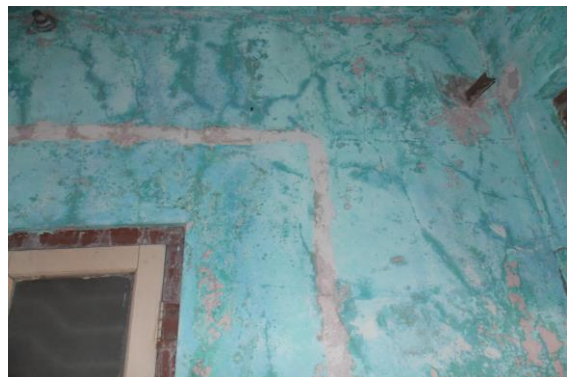
Photo 50

Peeling of Plaster on Wall No. 2 of Staircase Second Floor To Third Floor of House Above Shop No.355 to 358, Second Floor

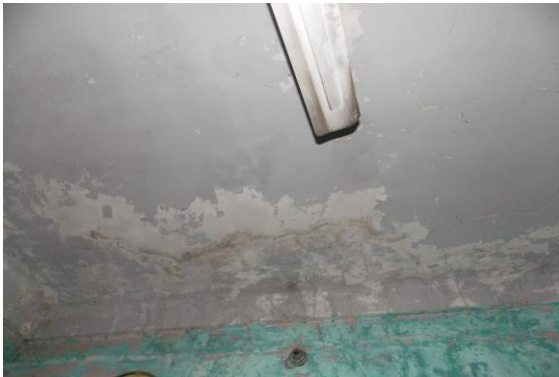
Photo 51

Dampness/Seepage on Wall No. 1 of Room No. 1 of House Above Shop No.355 to 358, Second Floor

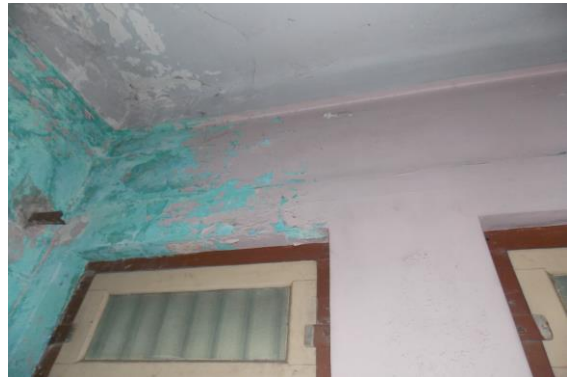
Photo 52

Dampness/Seepage on Roof of Room No. 1 of House Above Shop No.355 to 358, Second Floor

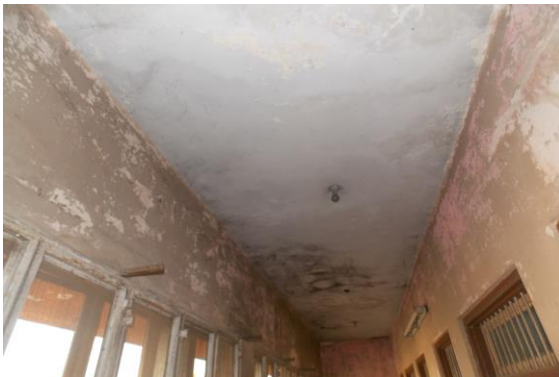
Photo 53

Dampness/Seepage on Wall No. 4 of Room No. 1 of House Above Shop No.355 to 358, Second Floor

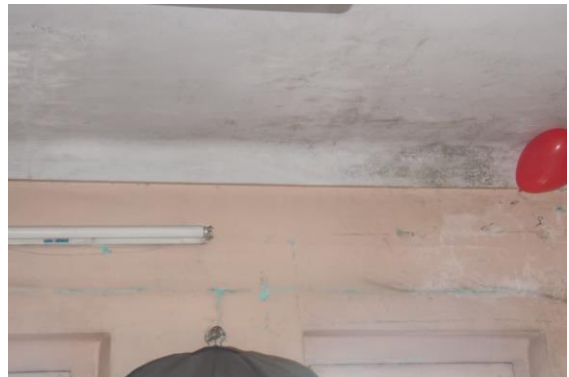
Photo 54

Dampness/Seepage on All Walls & Roof of Balcony of House Above Shop No.355 to 358, Second Floor

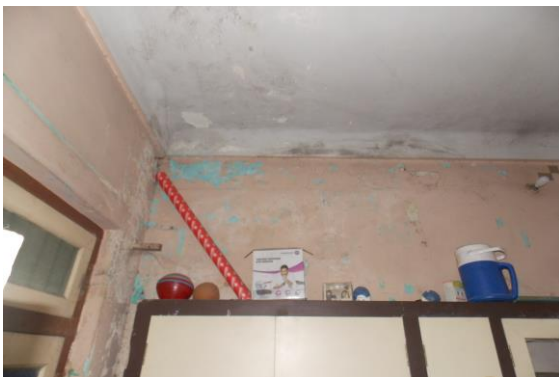
Photo 55

Dampness/Seepage on Wall No. 4 & Roof of Room No. 2 of House Above Shop No.355 to 358, Second Floor

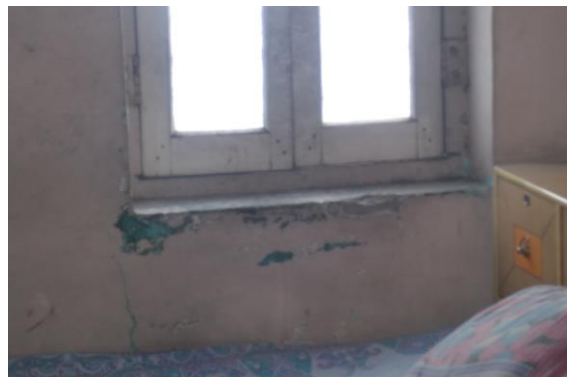
Photo 56

Dampness/Seepage on Wall No. 1 & Roof of Room No. 2 of House Above Shop No.355 to 358, Second Floor

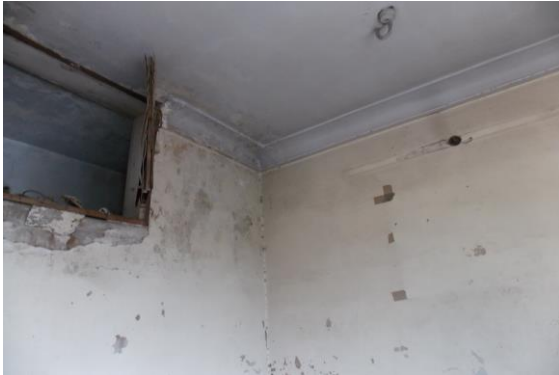
Photo 57

Peeling of Plaster on Wall No. 4 of Room No. 2 of House Above Shop No.355 to 358, Second Floor

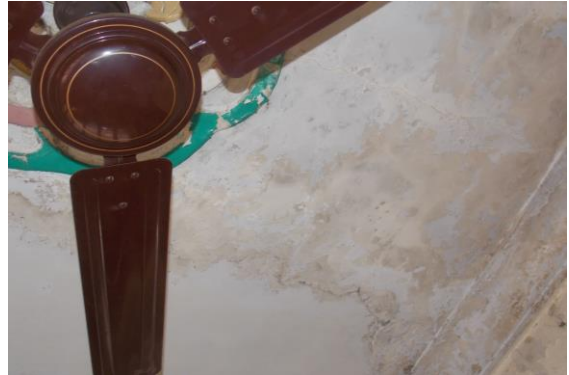
Photo 58

Dampness/Seepage on Wall No. 3, Roof & 1 of Room No. 3 of House Above Shop No.355 to 358, Second Floor

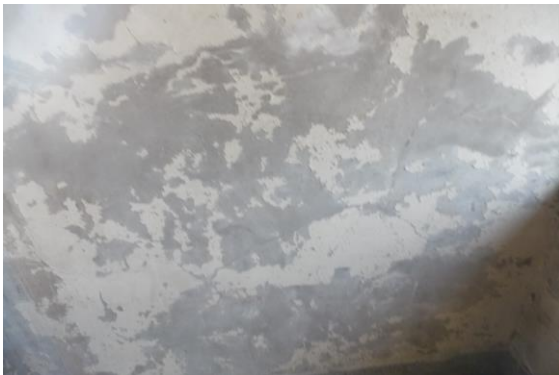
Photo 59

Peeling of Plaster on Roof of Room No. 3 of House Above Shop No.355 to 358, Second Floor

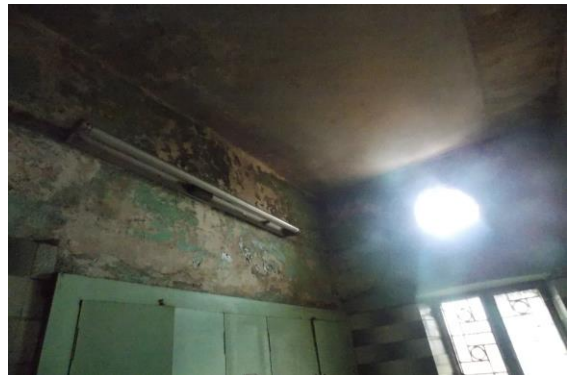
Photo 60

Dampness/Seepage on Wall No. 4 of Room No. 3 of House Above Shop No.355 to 358, Second Floor

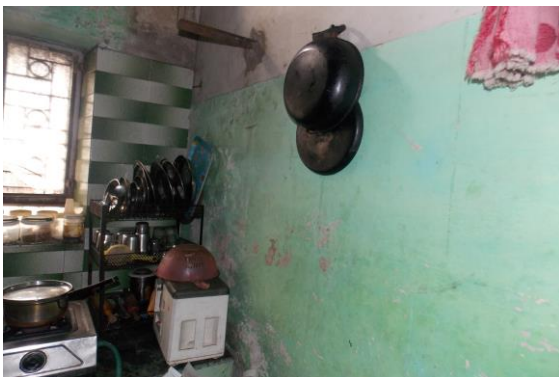
Photo 61

Dampness/Seepage on Wall No. 1, 4 & Roof of Kitchen of House Above Shop No.355 to 358, Second Floor

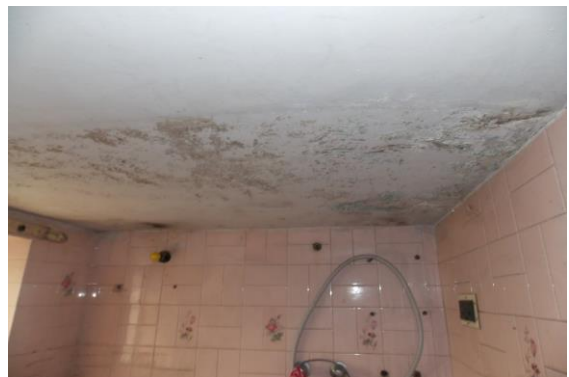
Photo 62

Dampness/Seepage on Wall No. 2 of Kitchen of House Above Shop No.355 to 358, Second Floor

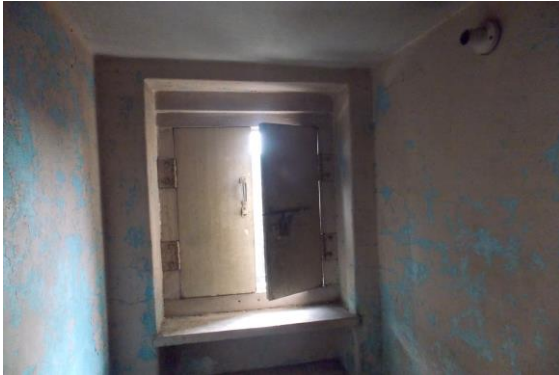
Photo 63

Dampness/Seepage on Roof of Toilet No. 1 of House Above Shop No.355 to 358, Second Floor

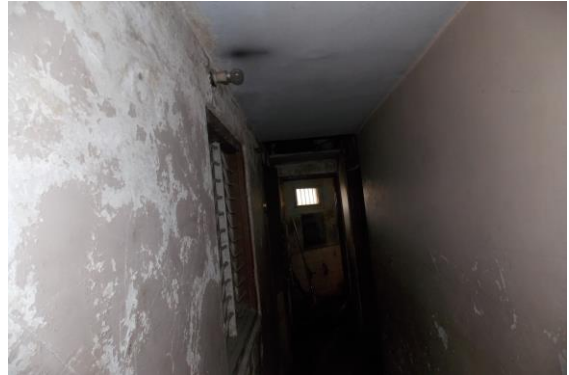
Photo 64

Peeling of Plaster on All Walls of Toilet No. 1 of House Above Shop No.355 to 358, Second Floor

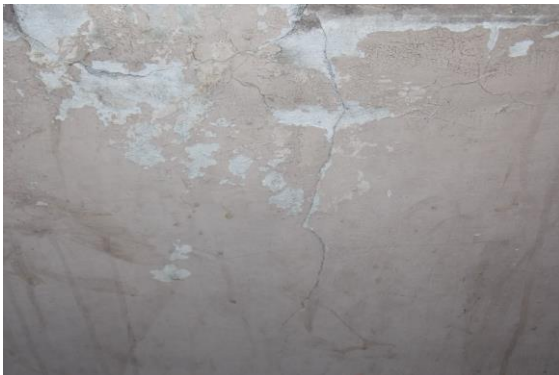
Photo 65

Peeling of Plaster on All Walls & Roof of Passage of House Above Shop No.355 to 358, Second Floor

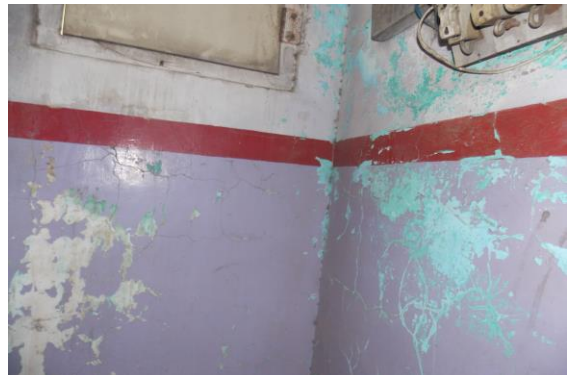
Photo 66

Peeling of Plaster on Wall No. 4 of House Above Shop No.355 to 358 of House Above Shop No.355 to 358, Second Floor

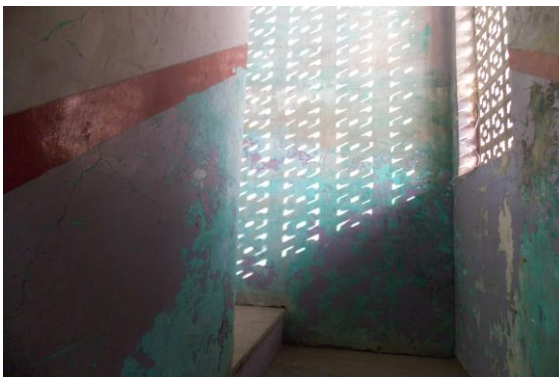
Photo 67

Dampness/Seepage on Wall No. 2 & 3 of Staircase of House Above Shop No.355 to 358, Second Floor

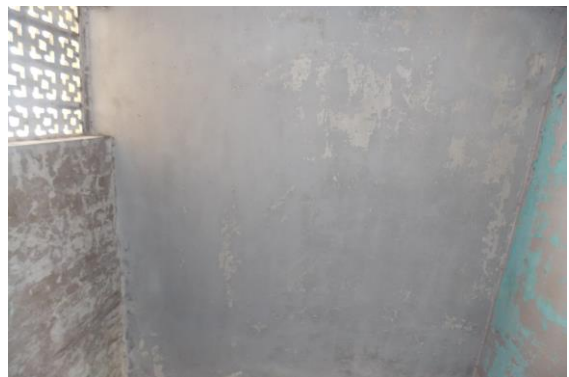
Photo 68

Dampness/Seepage on Wall No. 1 & 4 of Staircase of House Above Shop No.355 to 358, Second Floor

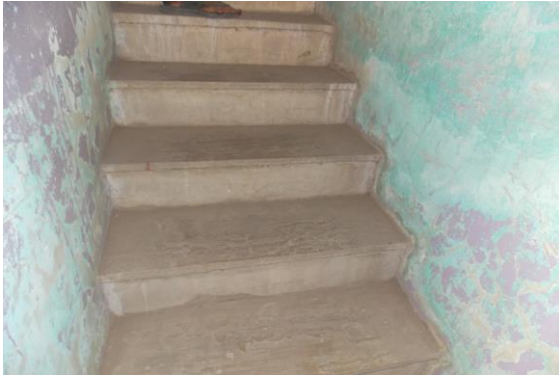
Photo 70

Peeling of Plaster on Wall No. 1 & 2 of Staircase of Terrace

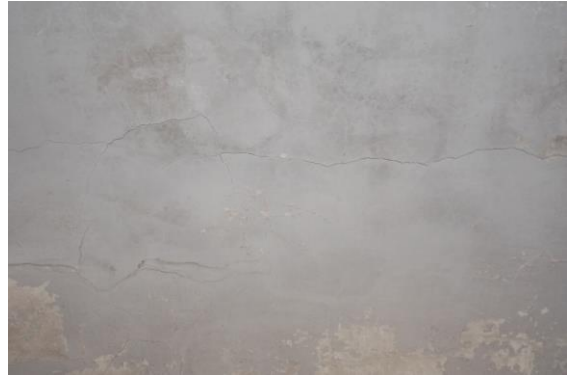
Photo 71

Plaster Crack on Roof of Staircase of Terrace

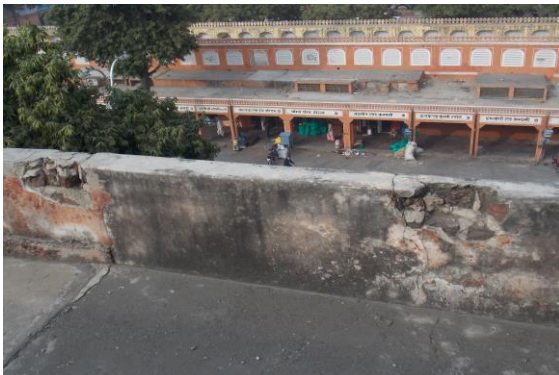
Photo 72

Damaged Portion on Wall No. 4 of Boundary Wall of Terrace

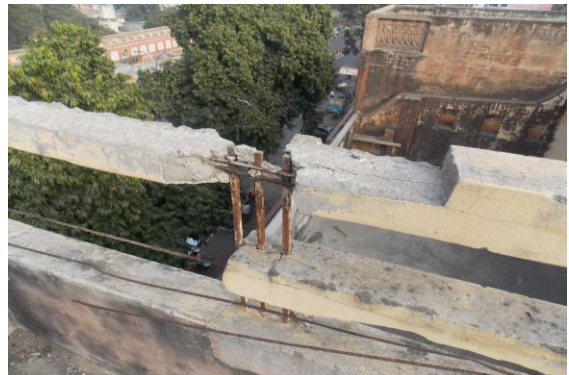
Photo 73

Damaged Portion on Wall No. 2 of Boundary Wall of Terrace

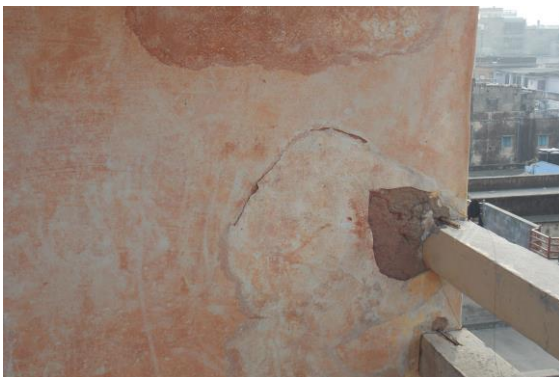
Photo 74

Peeling of Plaster on Wall No. 3 of Boundary Wall of Terrace

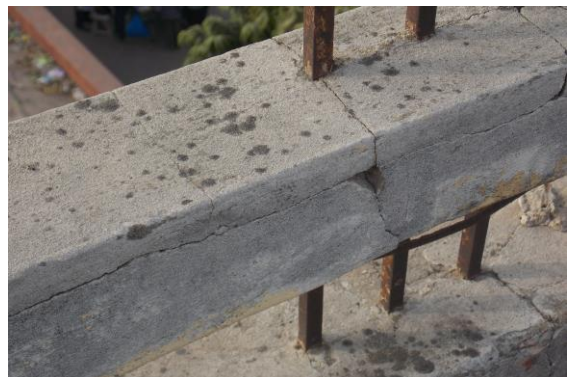
Photo 75

Damaged Portion on Wall No. 1 of Boundary Wall of Terrace

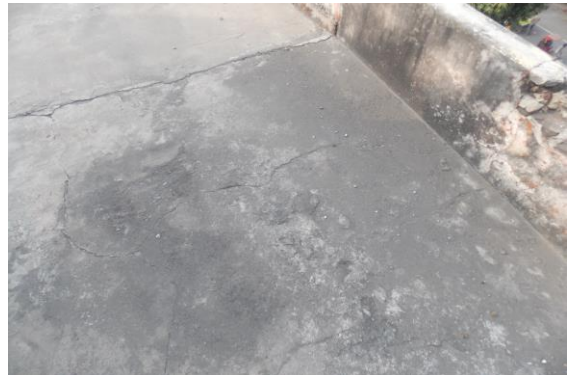
Photo 77

Plaster Crack on Floor of Boundary Wall of Terrace

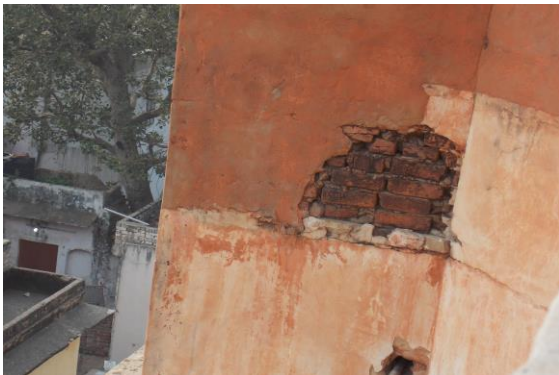
Photo 78

Damaged Portion on External Wall of Backside of Forth Floor

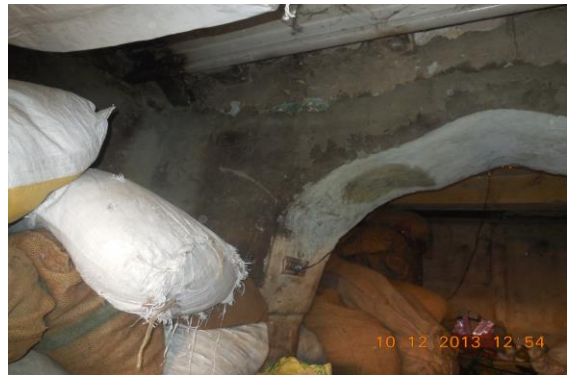
Photo 79

Wall No. 1 of Part A of Shop No.357 of Ground Floor Partially Covered With Material

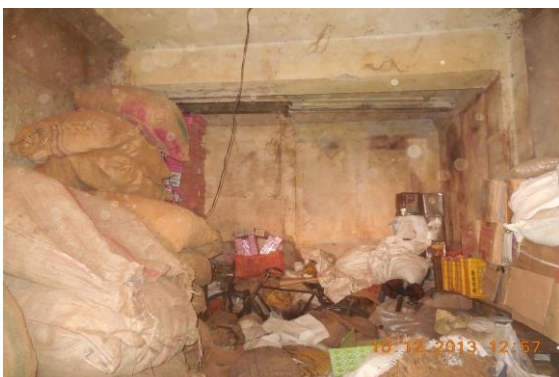
Photo 80

All Walls of Part B of Shop No.357 of Ground Floor Partially Covered With Material

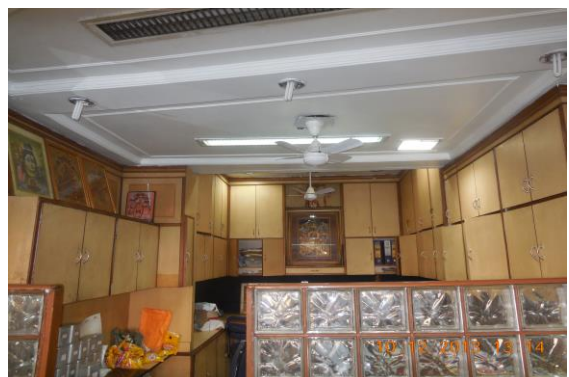
Photo 81

All Walls of Shop No.356 of Ground Floor Covered With Wooden Work & Material

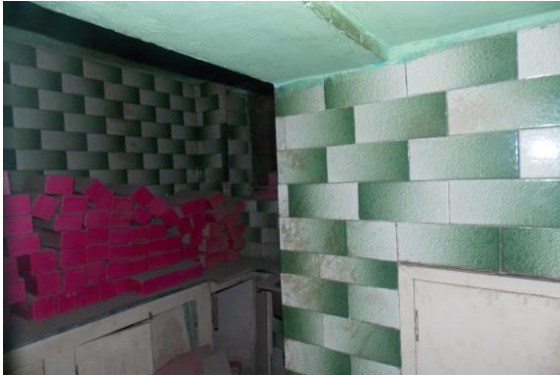
Photo 82

All Walls of Kitchen of House Above Shop No.355 to 358, First Floor Covered With Tiles

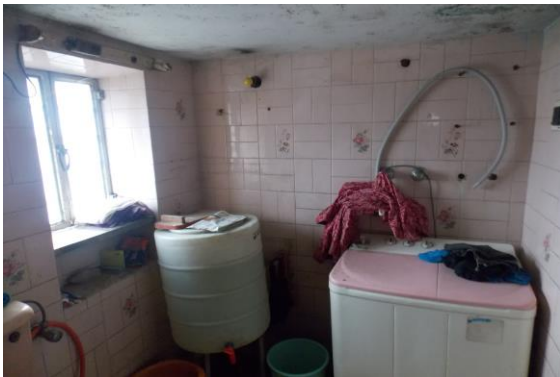
Photo 84

All Walls of Toilet No. 1 of House Above Shop No.355 to 358, Second Floor Covered With Tiles

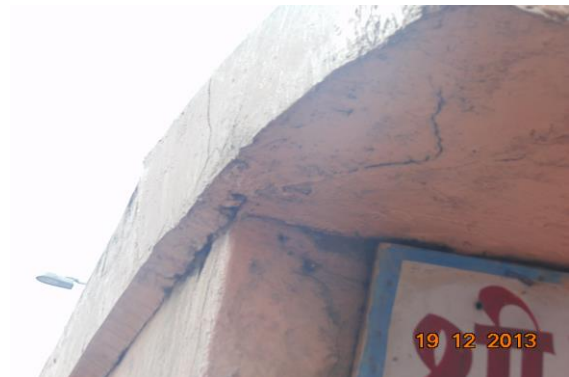
Summary of Defects Other Than Crack			
Defect ID	Location	Description	Photo No.
1	Roof Side Temple Ground Floor	Damaged Portion	4
2	Beam Temple Ground Floor	Peeling of Plaster	5
3	Beam Temple Ground Floor	Dampness/Seepage	6
4	Floor Temple Ground Floor	Damaged Portion	7

Photo 4
Damaged Portion on Roof Side of Temple of Ground Floor

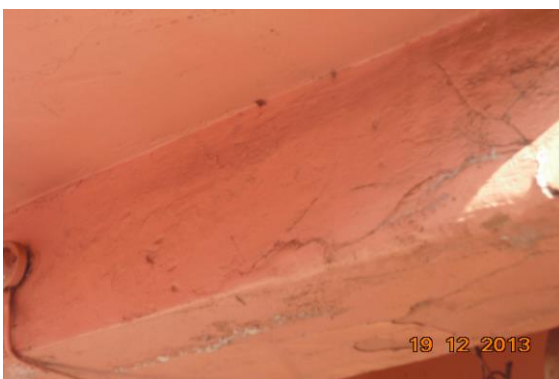
Photo 5
Peeling of Plaster on Beam of Temple of Ground Floor

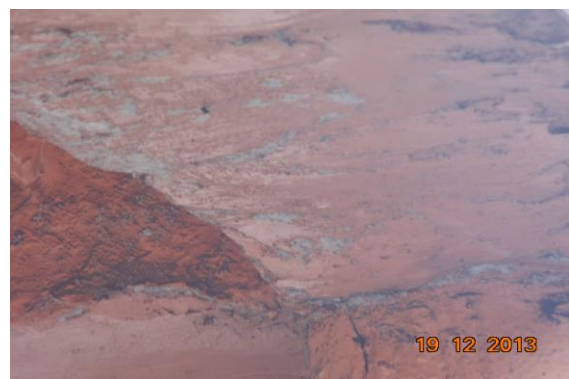
Photo 6
Dampness/Seepage on Beam of Temple of Ground Floor

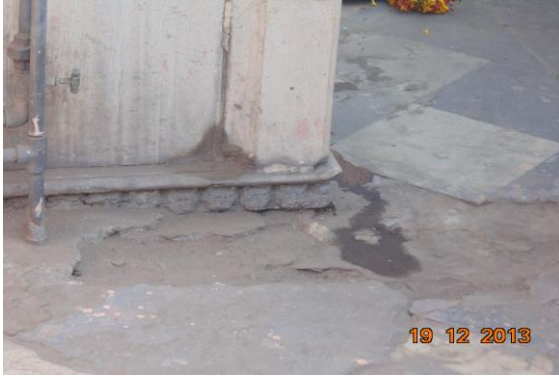
Photo 7

Damaged Portion on Floor of Temple of Ground Floor

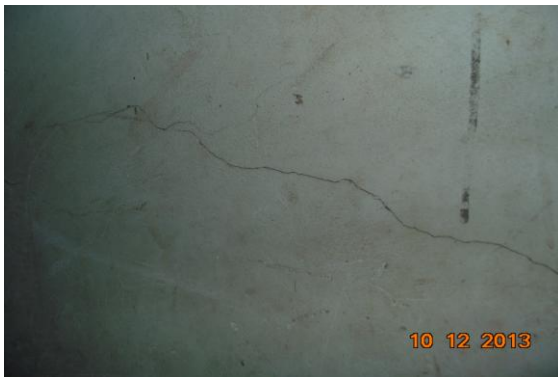
Summary of Cracks						
Defect ID	Location	Orientation	Appx. Width (mm)	Appx. Length (m)	Category	Photo No.
1	Staircase FF to SF	Horizontal	0.3	1.1	Very Slight	3, 3A
2	Wall No. 1 Staircase FF to SF	Inclined	0.2	0.8	Very Slight	4, 4A
3	Wall No. 4 Room No. 2 Second Floor	Inclined	0.3	1.2	Very Slight	5, 5A
4	Wall No. 2 Room No. 2 Second Floor	Horizontal	3	3	Slight	6
5	Wall No. 2 Room No. 3 Second Floor	Inclined	0.6	1.7	Very Slight	7, 7A
6	Wall No. 1 Room No. 4 Second Floor	Inclined	0.5	2.5	Very Slight	8, 8A
7	Wall No. 1 Room No. 4 Second Floor	Inclined	0.4	3.5	Very Slight	9, 9A
8	Wall No. 1 Room No. 4 Second Floor	Inclined	0.3	0.8	Very Slight	10, 10A
9	Wall No. 4 Room No. 4 Second Floor	Inclined	0.35	0.8	Very Slight	11
10	Roof Room No. 1 Third Floor	Horizontal	0.35	1.5	Very Slight	12
11	Outer Wall Third Floor	Inclined	2.5	1	Slight	13
12	Outer Wall Third Floor	Inclined	0.6	0.5	Very Slight	14, 14A
13	Roof Varanda of Shop no.354 Ground Floor	Horizontal	0.35	3	Very Slight	15

Photo 3
Horizontal Crack on of Staircase FF to SF, Approx. Width = 0.3mm,
Approx. Length = 1.1m.
Distance from Wall no.4 = 0.25m, Height from Floor = 1.6m.

Photo 3A
Horizontal Crack on of Staircase FF to SF, Approx. Width = 0.3mm,
Approx. Length = 1.1m.
Distance from Wall no.4 = 0.25m, Height from Floor = 1.6m.

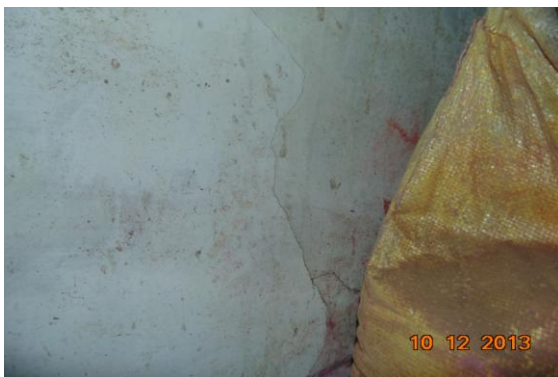
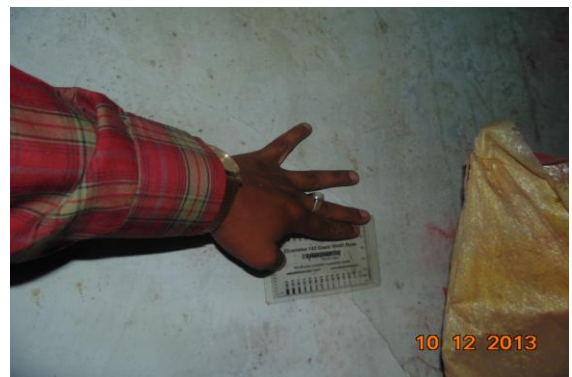
Photo 4
Inclined Crack on Wall No. 1 of Staircase FF to SF, Approx. Width =
0.2mm, Approx. Length = 0.8m.
Distance from Wall No.3 = 1m, Height from Floor = 0m.

Photo 4A
Inclined Crack on Wall No. 1 of Staircase FF to SF, Approx. Width =
0.2mm, Approx. Length = 0.8m.
Distance from Wall No.3 = 1m, Height from Floor = 0m.

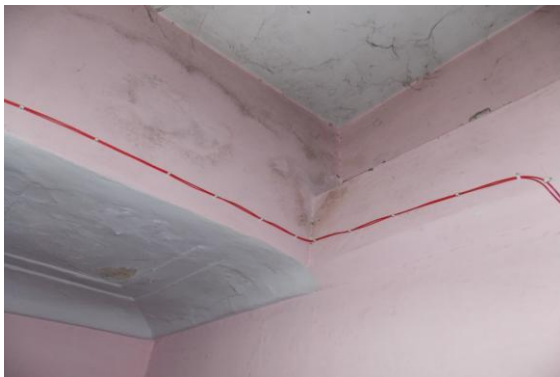
Photo 3
Inclined Crack on Wall No. 3 of Room No. 1, Second Floor, Approx.
Width = 0.2mm, Approx. Length = 1.2m.
Distance from Wall no.1 = 0m, Height from Floor = 3m.
