Pre Building Condition Survey Report

Name and Address of Structure :	Choti Chopar to Badi Chopar (Down Line)
---------------------------------	---

Name of the Project	Contract JMRC-UG1B “Design and Construction of Tunnel between Chandpole and Badi Chouper and reverse line by Shield TBM, Underground Metro Stations at Choti Chouper and Badi Chouper by Cut and Cover Methods on East West Corridor of Jaipur Metro Rail Corporation Limited .”	
Owner :

Pre Building Condition Survey Report Choti Chopar to Badi Chopar (Down Line)

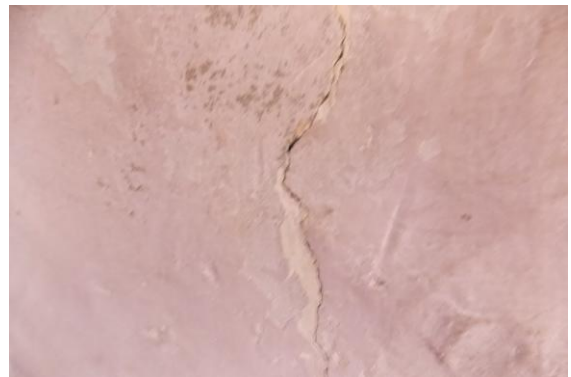
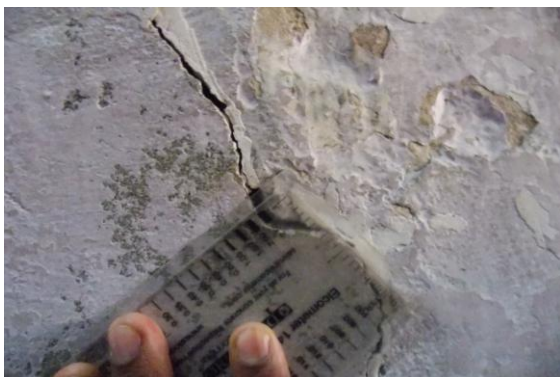
Photo 4
Inclined Crack on Wall No. 2 of Staircase, Ground Floor, Approx. Width
= 2.5mm, Approx. Length = 1.8m.
Distance from Wall no.3 = 2.3m, Height from Floor = 0m.

Photo 4A
Inclined Crack on Wall No. 2 of Staircase, Ground Floor, Approx. Width
= 2.5mm, Approx. Length = 1.8m.
Distance from Wall no.3 = 2.3m, Height from Floor = 0m.

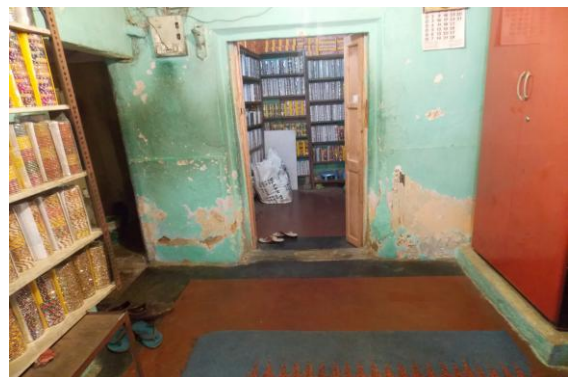
Photo 5
Peeling of Plaster on Wall No. 1 of Room No. 1 of First Floor

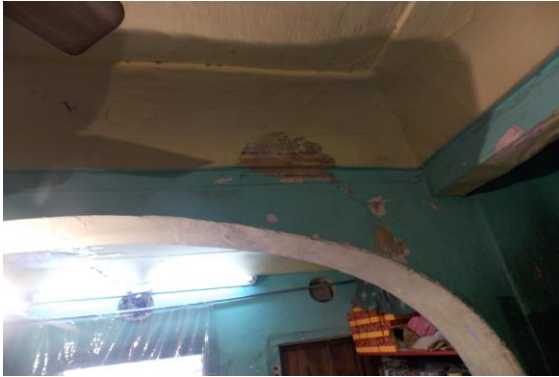
Photo 6

Peeling of Plaster on Wall No. 2 of Room No. 1 of First Floor

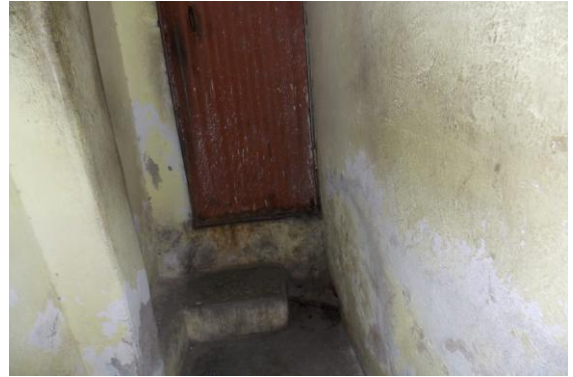
Photo 7

Dampness/Seepage on Wall No. 2 & 4 of Toilet No. 1 of First Floor

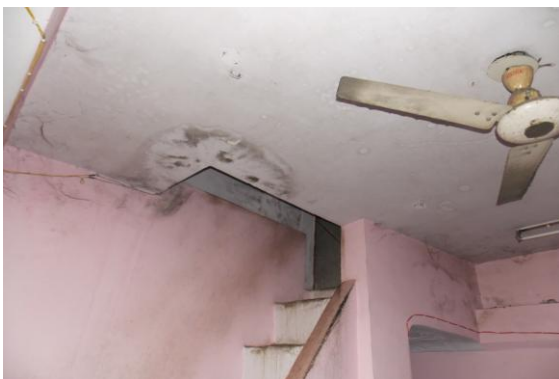
Photo 9

Dampness/Seepage on Wall No. 1 of Room No. 1 of Second Floor

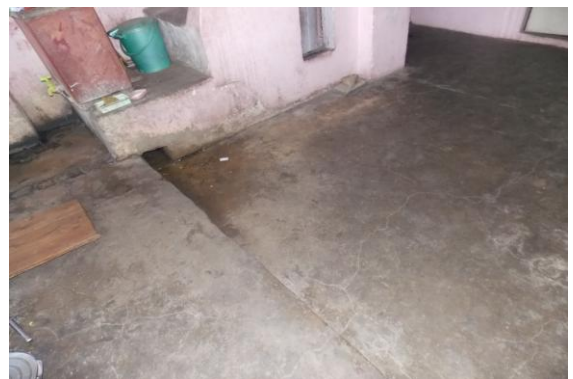
Photo 10

Dampness/Seepage on Roof of Room No. 1 of Second Floor

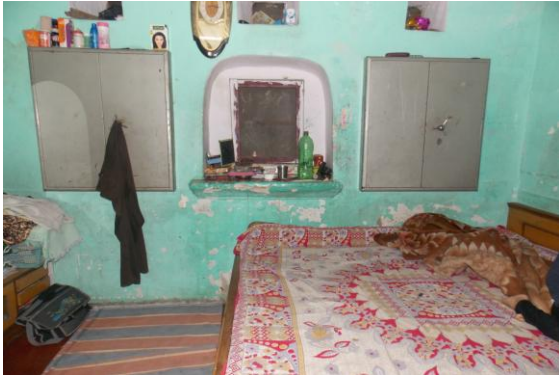
Photo 12

Dampness/Seepage on Wall No. 4 of Room No. 2 of Second Floor

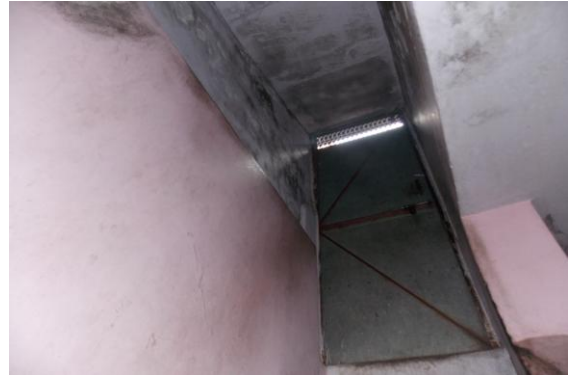
Photo 13

Dampness/Seepage on Staircase SF to Terrace

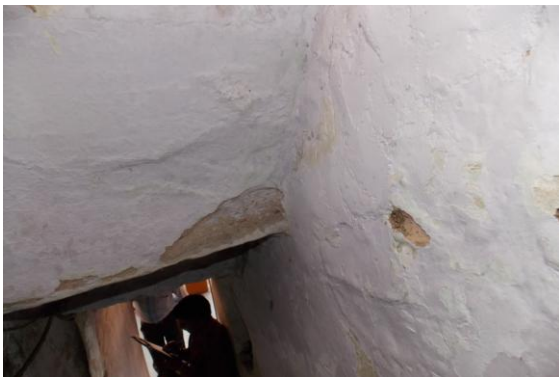
Photo 14

Peeling of Plaster on Roof & 1 of Staircase FF to SF of

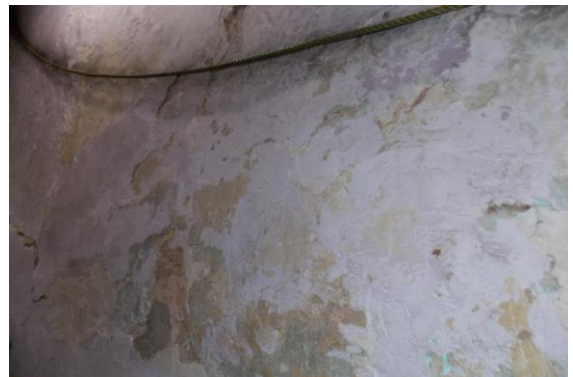
Photo 15

Peeling of Plaster on Wall No. 2 of Staircase FF to SF

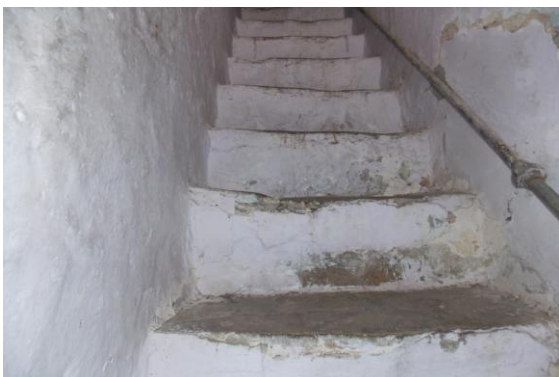
Photo 16

Damaged Portion on Steps of Staircase of Ground Floor

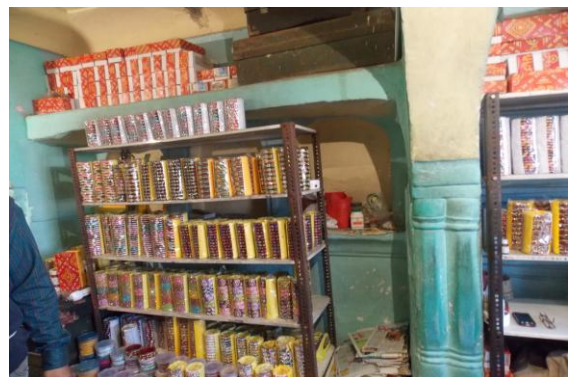
Photo 17

Wall No. 4 of Room No. 1 of First Floor Covered With material

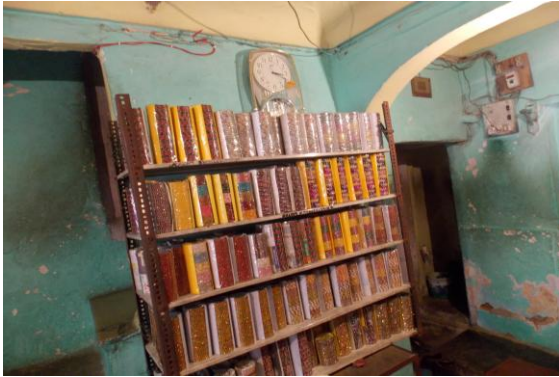
Photo 18

Wall No. 3 of Room No. 1 of First Floor Covered With material

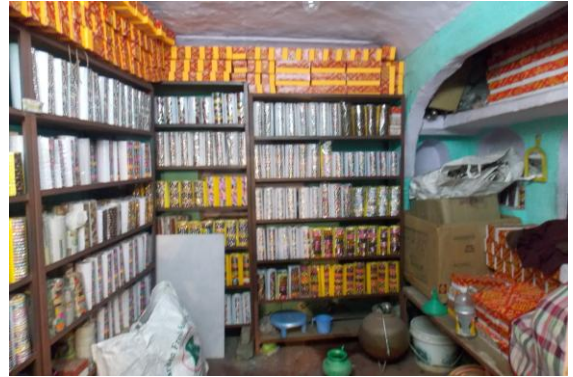
Photo 19

All Walls of Room No. 2 of First Floor Covered With material

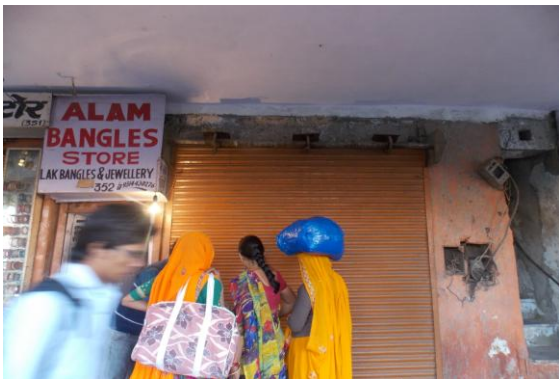
Photo 20

Shop No.352 of Ground Floor Covered

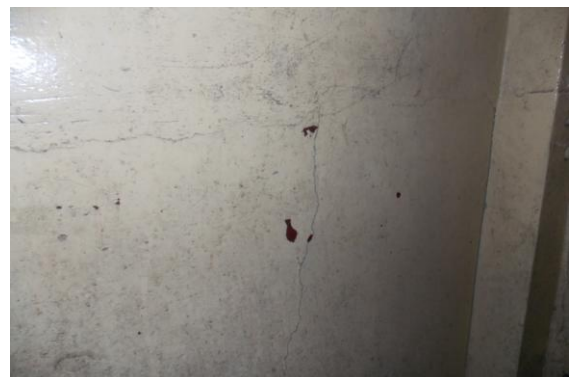
Photo 6
Inclined Crack on Wall No. 1 of Toilet No. 1, First Floor, Approx. Width = 0.3mm, Approx. Length = 0.5m.
Distance from Wall No.3 = 2m, Height from Floor = 0.4m.

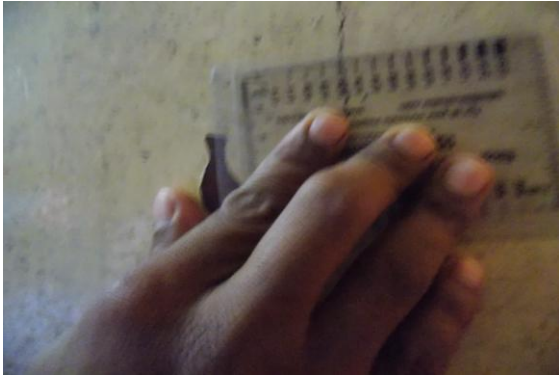
Photo 6A

Inclined Crack on Wall No. 1 of Toilet No. 1, First Floor, Approx. Width = 0.3mm, Approx. Length = 0.5m.
Distance from Wall No.3 = 2m, Height from Floor = 0.4m.

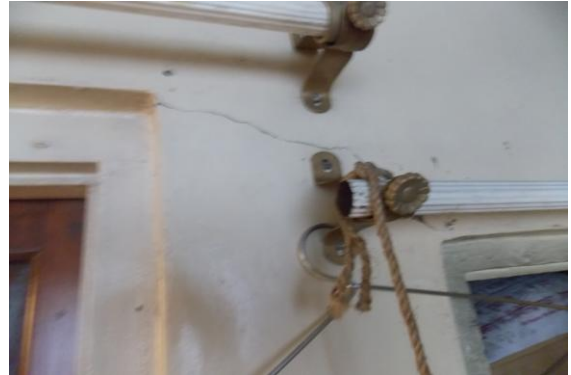
Photo 7

Inclined Crack on Wall No. 1 of Room No. 1, Second Floor
Approx. Width = 0.3mm, Approx. Length = 0.3m.
Distance from Wall No.4 = 1.2m, Height from Floor = 1.6m.

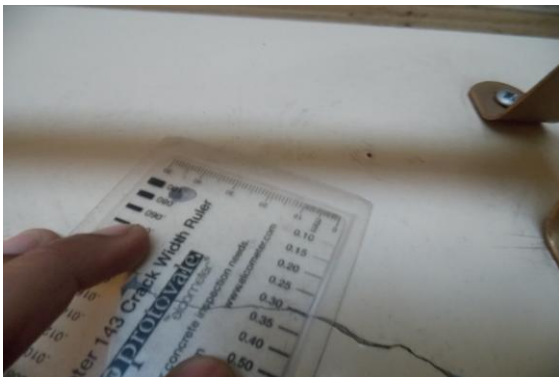
Photo 7A

Inclined Crack on Wall No. 1 of Room No. 1, Second Floor
Approx. Width = 0.3mm, Approx. Length = 0.3m.
Distance from Wall No.4 = 1.2m, Height from Floor = 1.6m.

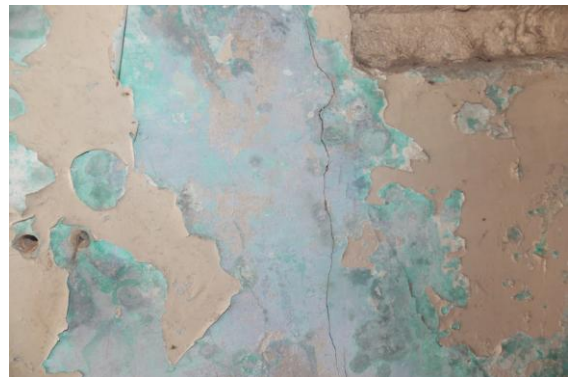
Photo 8

Vertical Crack on Wall No. 4 of Room No. 2, Third Floor, Approx. Width = 0.35mm, Approx. Length = 1.5m.
Distance from Wall no.2 = 0m, Height from Floor = 1m.

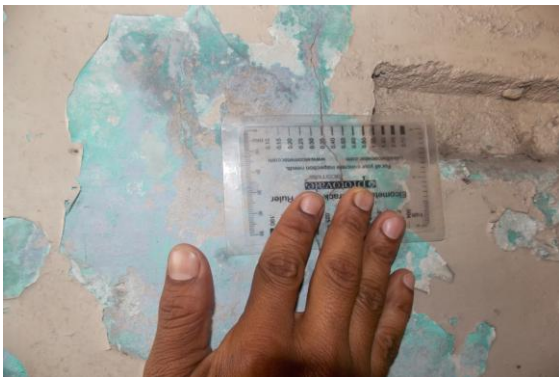
Photo 8A

Vertical Crack on Wall No. 4 of Room No. 2, Third Floor, Approx. Width = 0.35mm, Approx. Length = 1.5m.
Distance from Wall no.2 = 0m, Height from Floor = 1m.

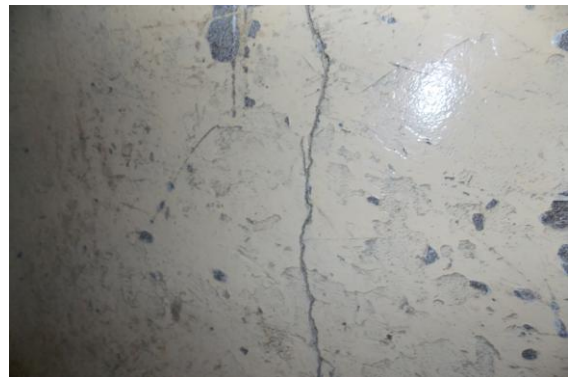
Photo 9

Inclined Crack on Wall No. 2 of Staircase, Approx. Width = 1.5mm, Approx. Length = 1.7m.
Distance from Wall no.3 = 2.5m, Height from Floor = 0m.

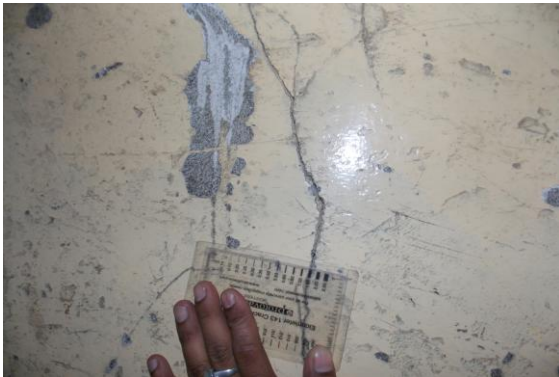
Photo 9A

Inclined Crack on Wall No. 2 of Staircase, Approx. Width = 1.5mm,
Approx. Length = 1.7m.
Distance from Wall no.3 = 2.5m, Height from Floor = 0m.

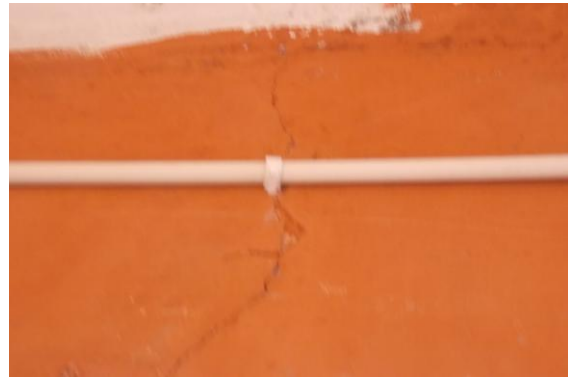
Photo 10

Inclined Crack on External Beam of Varanda of H.No.70, Approx. Width
= 1mm, Approx. Length = 0.7m.
Distance from = Backside External Columnm, Height from Floor = 2m.

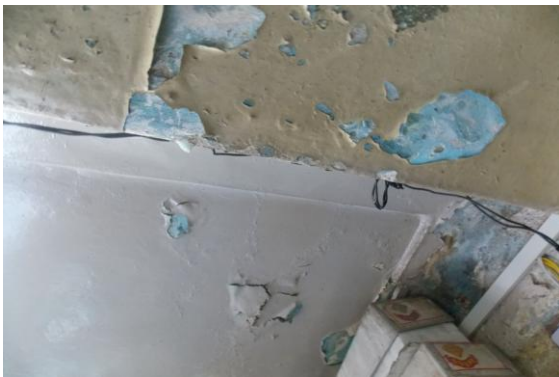
Photo 11

Peeling of Plaster on Roof of Room No. 1 of First Floor

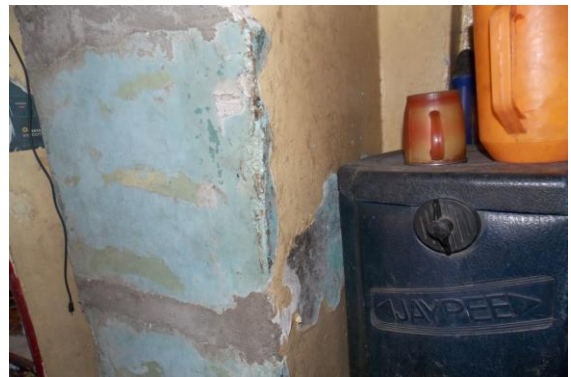
Photo 12

Peeling of Plaster on Wall No. 1 of Staircase area of First Floor

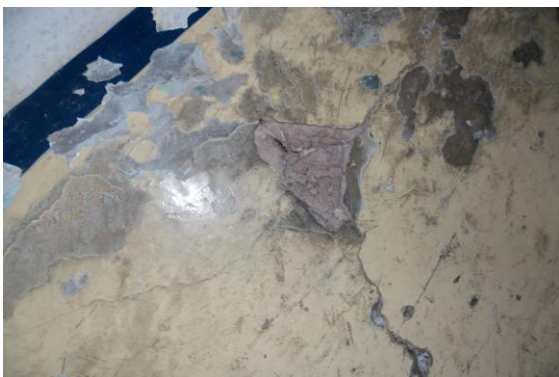
Photo 13

Peeling of Plaster on Wall No. 2 of Staircase area of First Floor

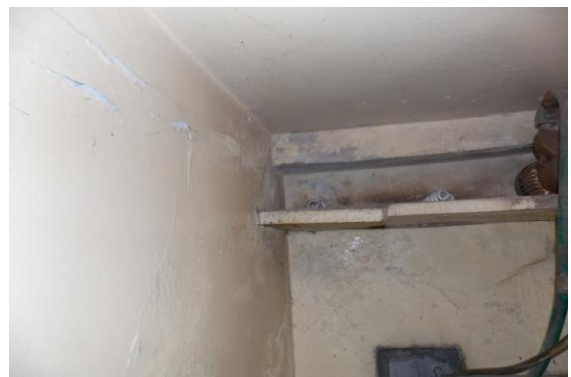
Photo 14

Peeling of Plaster on Wall No. 4 of Toilet No. 1 of First Floor

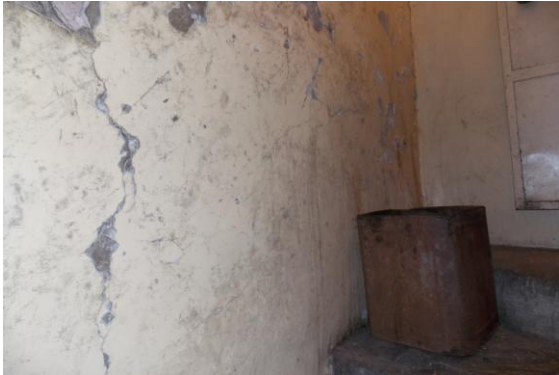
Photo 15

Peeling of Plaster on Wall No. 4 of Staircase area of First Floor

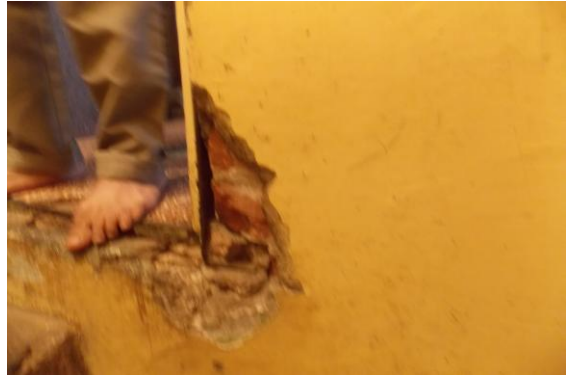
Photo 16

Damaged Portion on Wall No. 3 of Staircase area of First Floor

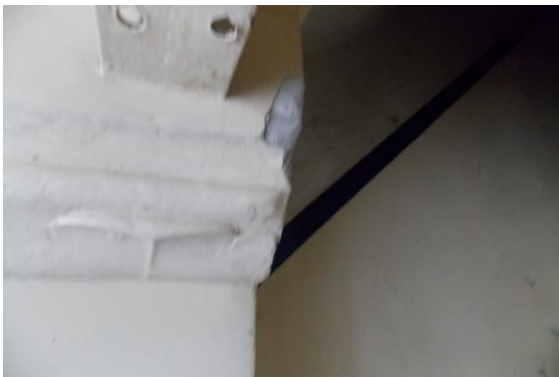
Photo 17

Peeling of Plaster on Wall No. 4 of Staircase area of First Floor

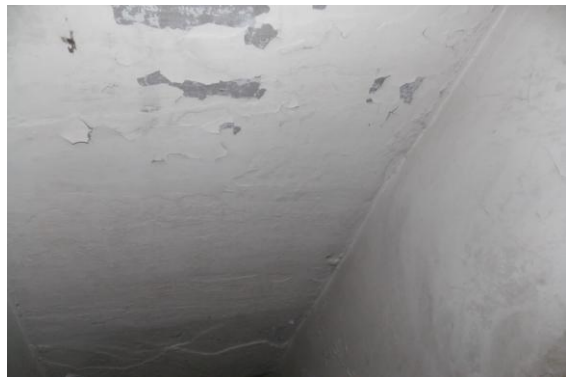
Photo 18

Peeling of Plaster on Roof of Staircase area of Second Floor

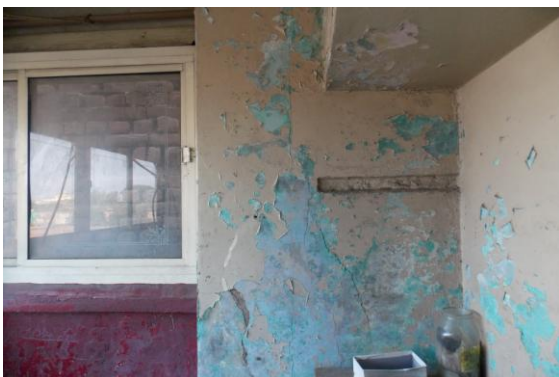
Photo 19

Peeling of Plaster on Wall No. 2 of Room No. 2 of Third Floor

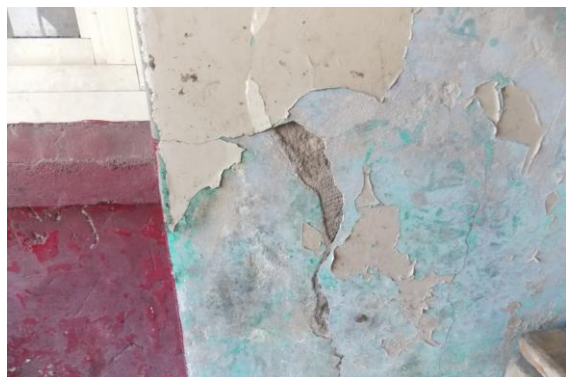
Photo 20

Peeling of Plaster on Wall No. 4 of Room No. 2 of Third Floor

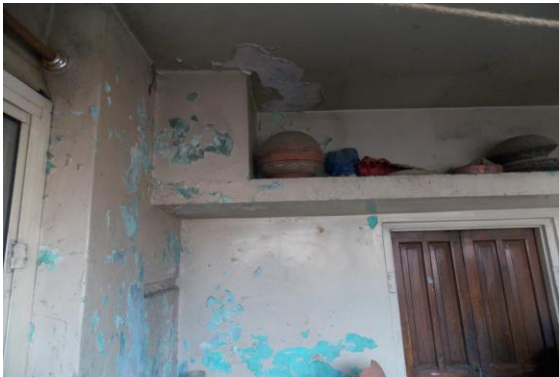
Photo 21

Peeling of Plaster on Wall No. 2 & Roof of Room No. 2 of Third Floor

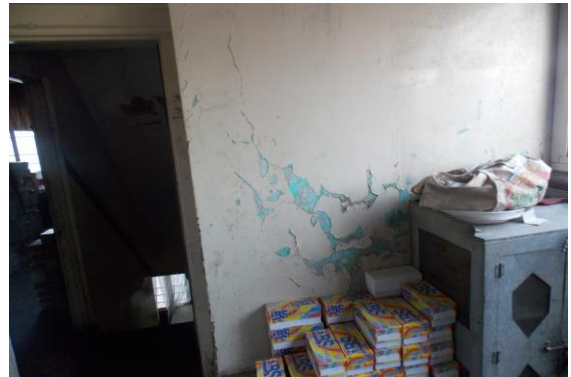
Photo 22

Peeling of Plaster on Wall No. 3 of Room No. 2 of Third Floor

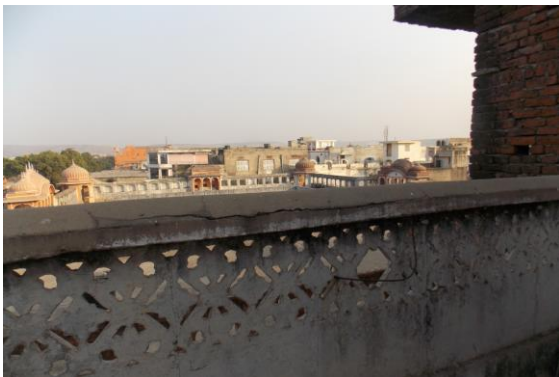
Photo 23

Damaged Portion on Perapet Wall of Terrace

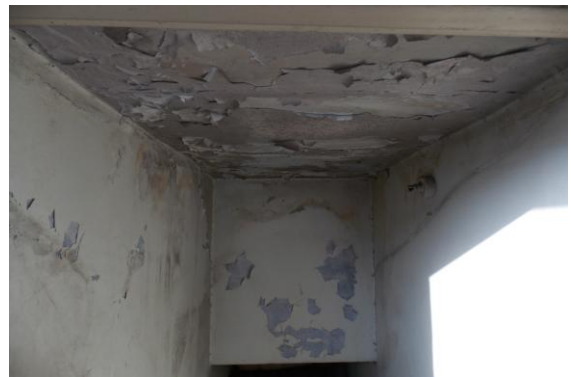
Photo 24

Peeling of Plaster on Roof of Staircase TF to Terrace of Terrace

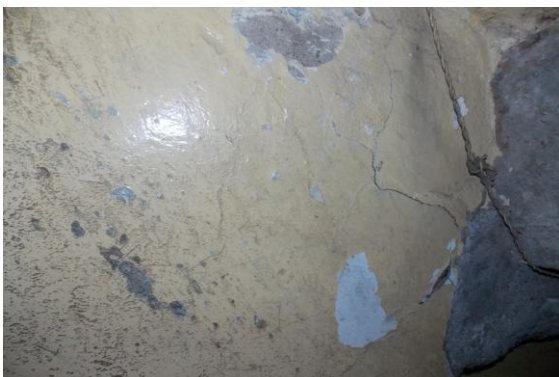
Photo 25

Peeling of Plaster on Wall No. 2 of Staircase GF to FF

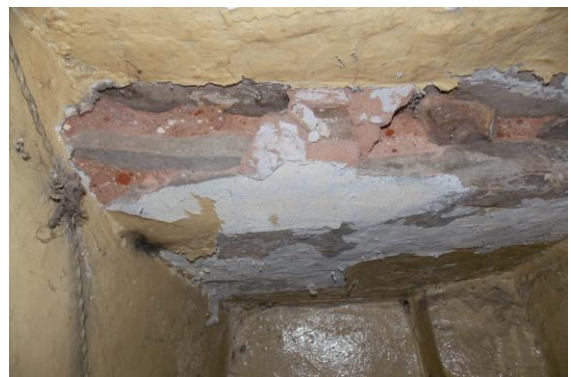
Photo 26

Damaged Portion on Roof of Staircase

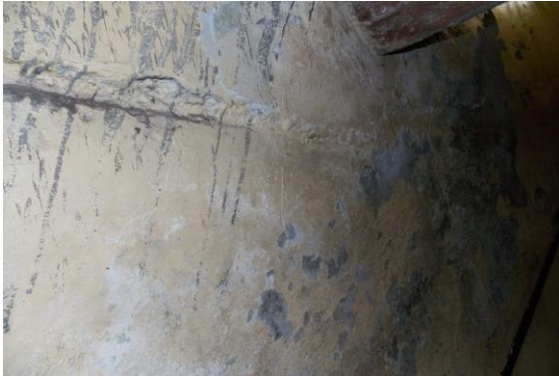
Photo 27
Peeling of Plaster on Wall No. 1 of Staircase

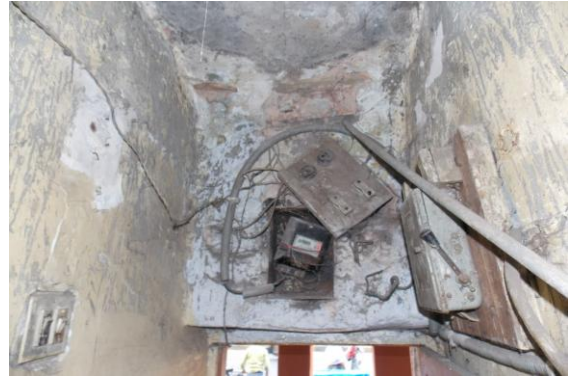
Photo 28
Damaged Portion on Wall No. 3 of Staircase

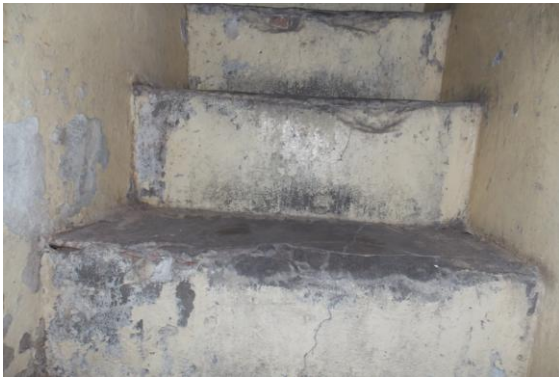
Photo 29
Damaged Portion on Steps of Staircase of

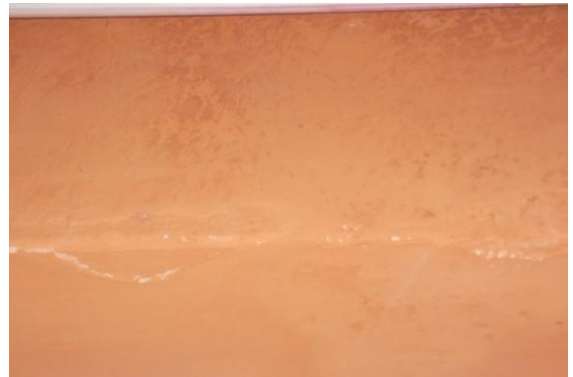
Photo 30
Peeling of Plaster on External Beam of Varanda of H.No.70 of

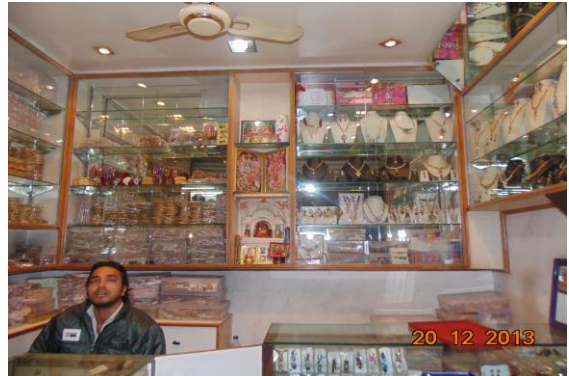
Summary of Areas that Could not be Surveyed			
Serial No.	Location	Description	Photo No.
1	Wall No. 1, 2 & 4	Covered With Material	2
2	Roof	Covered With False Ceiling	3

Photo 2
Wall No. 1, 2 & 4 of of Covered With Material

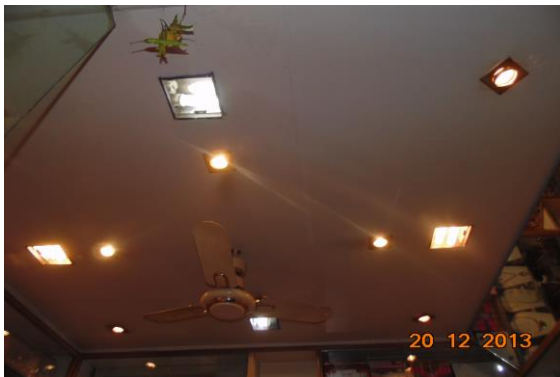
Photo 3
Roof of Covered With False Ceiling

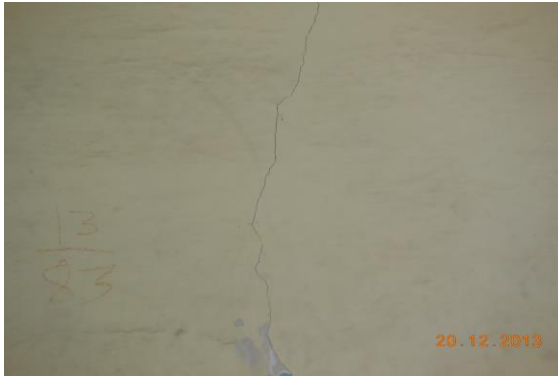
Photo 7

Summary of Cracks						
Defect ID	Location	Orientation	Appx. Width (mm)	Appx. Length (m)	Category	Photo No.
1	Wall No. 3 Varanda Ground Floor	Inclined	0.35	1	Very Slight	7, 7A
2	Wall No. 3 & Roof Varanda Ground Floor	Inclined	0.35	2	Very Slight	8
3	Wall No. 1 Open sky Ground Floor	Vertical	8	2	Moderate	9
4	Roof Hall No. 1 Ground Floor	Inclined	0.3	3	Very Slight	10
5	Wall No. 4 Hall No. 1 Ground Floor	Inclined	0.4	1.5	Very Slight	11, 11A
6	Wall No. 4 Room No. 1 Part A of Room. Ground Floor	Horizontal	2.5	0.7	Slight	12
7	Roof Room No. 1 Part A of Room. Ground Floor	Inclined	0.3	2	Very Slight	13
8	Wall No. 3 Room No. 1 Part A of Room. Ground Floor	Inclined	0.6	1.5	Very Slight	14, 14A
9	Wall No. 3 Room No. 2 Ground Floor	Inclined	0.35	1.5	Very Slight	15, 15A
10	Roof Room No. 2 Ground Floor	Inclined	0.5	2	Very Slight	16
11	Roof Varanda No.2 Ground Floor	Inclined	1	2	Slight	17
12	Wall No. 1 Lobby no.2 Ground Floor	Inclined	1.5	0.2	Slight	18, 18A

Inclined Crack on Wall No. 3 of Varanda, Ground Floor
Approx. Width = 0.35mm, Approx. Length = 1m.
Distance from Wall No.2 = 2.3m, Height from Floor = 0.3m.

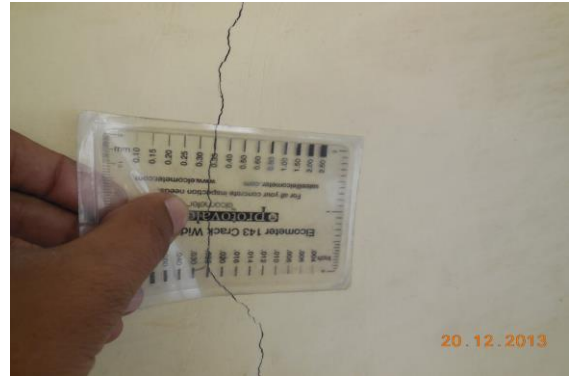
Photo 7A

Inclined Crack on Wall No. 3 of Varanda, Ground Floor
Approx. Width = 0.35mm, Approx. Length = 1m.
Distance from Wall No.2 = 2.3m, Height from Floor = 0.3m.

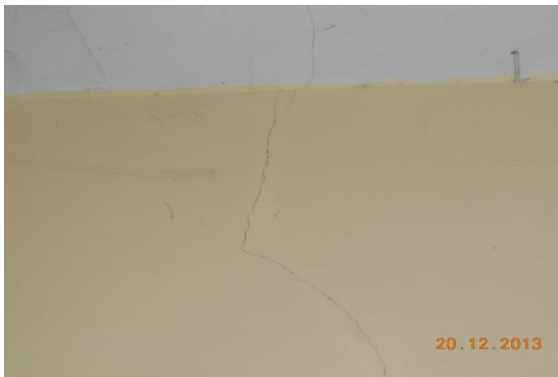
Photo 8

Inclined Crack on Wall No. 3 & Roof of Varanda, Ground Floor
Approx. Width = 0.35mm, Approx. Length = 2m.
Distance from Wall No.2 = 2.5m, Height from Floor = 1.75m.

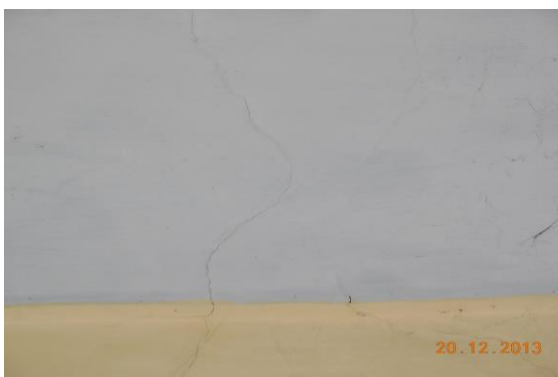
Photo 10

Inclined Crack on Roof of Hall No. 1, Ground Floor
Approx. Width = 0.3mm, Approx. Length = 3m.
Distance from = m, Height from Floor = m.

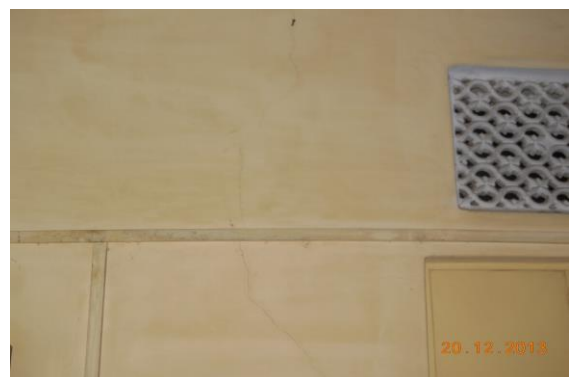
Photo 11

Inclined Crack on Wall No. 4 of Hall No. 1, Ground Floor
Approx. Width = 0.4mm, Approx. Length = 1.5m.
Distance from Wall No.1 = 1m, Height from Floor = 1m.

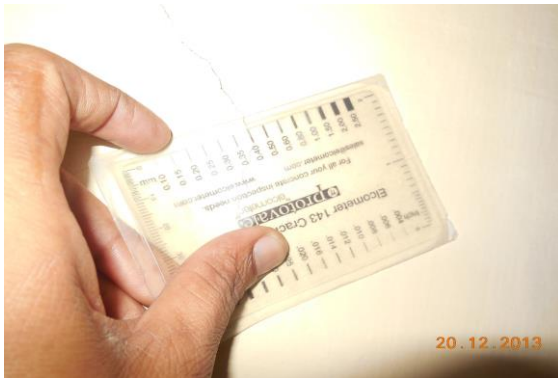
Photo 11A

Inclined Crack on Wall No. 4 of Hall No. 1, Ground Floor
Approx. Width = 0.4mm, Approx. Length = 1.5m.
Distance from Wall No.1 = 1m, Height from Floor = 1m.

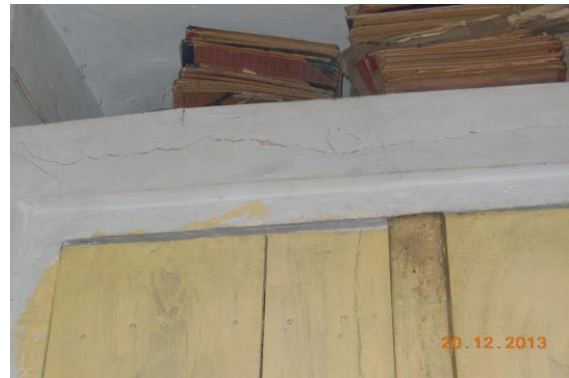
Photo 12

Horizontal Crack on Wall No. 4 of Room No. 1, Part A of Room. Ground Floor
Approx. Width = 2.5mm, Approx. Length = 0.7m. Distance from Wall no.1 = 0.4m, Height from Floor = 2.3m.

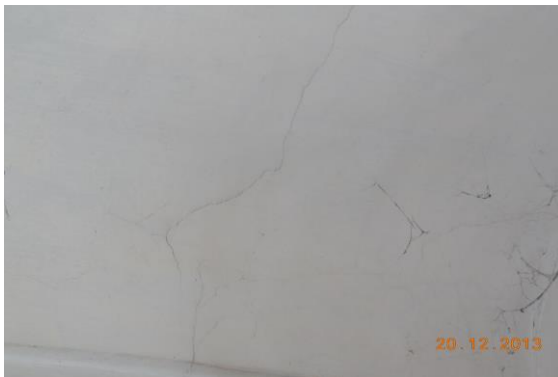
Photo 13

Inclined Crack on Roof of Room No. 1, Part A of Room. Ground Floor
Approx. Width = 0.3mm, Approx. Length = 2m.

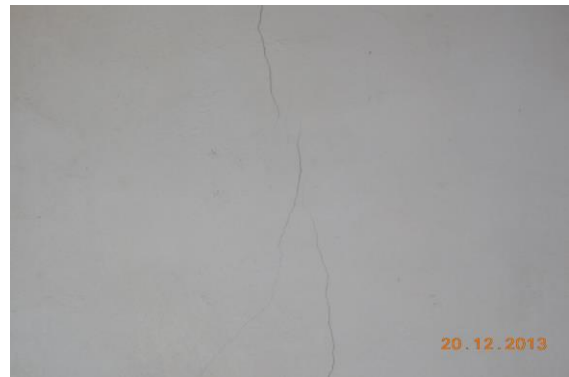
Photo 14

Inclined Crack on Wall No. 3 of Room No. 1, Part A of Room. Ground Floor
Approx. Width = 0.6mm, Approx. Length = 1.5m. Distance from Wall no.1 = 0.8m, Height from Floor = 1.5m.

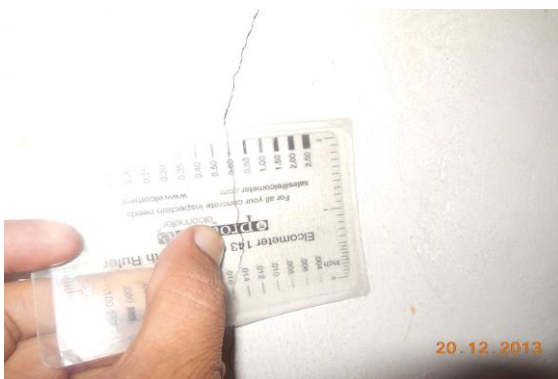
Photo 14A

Inclined Crack on Wall No. 3 of Room No. 1, Part A of Room. Ground Floor
Approx. Width = 0.6mm, Approx. Length = 1.5m. Distance from Wall no.1 = 0.8m, Height from Floor = 1.5m.

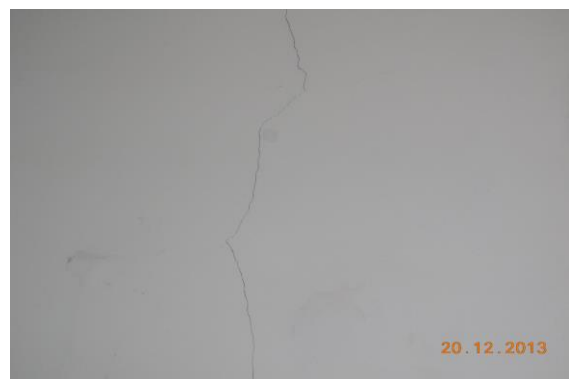
Photo 15

Inclined Crack on Wall No. 3 of Room No. 2, Ground Floor
Approx. Width = 0.35mm, Approx. Length = 1.5m.
Distance from Wall No.2 = 0.7m, Height from Floor = 1m.

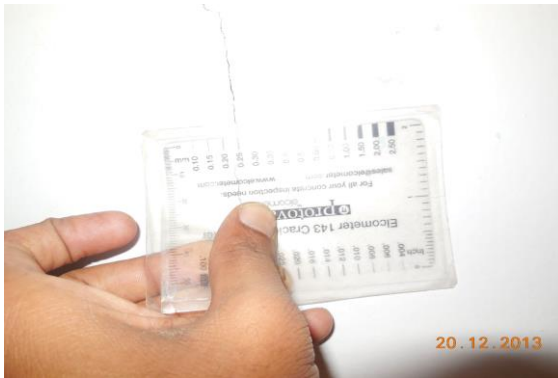
Photo 15A

Inclined Crack on Wall No. 3 of Room No. 2, Ground Floor
Approx. Width = 0.35mm, Approx. Length = 1.5m.
Distance from Wall No.2 = 0.7m, Height from Floor = 1m.

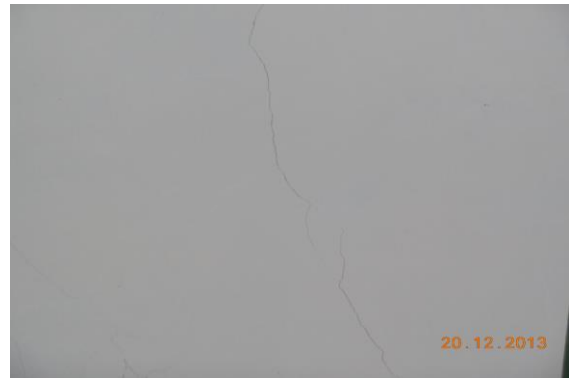
Photo 16

Inclined Crack on Roof of Room No. 2, Ground Floor
Approx. Width = 0.5mm, Approx. Length = 2m.

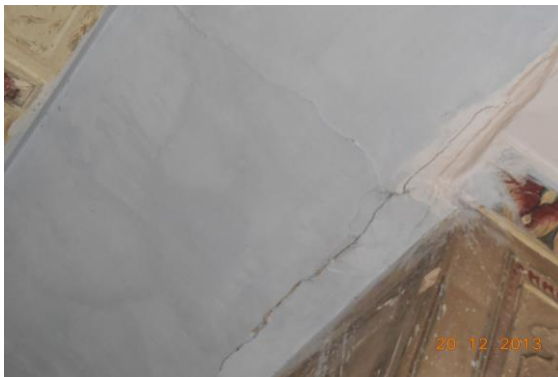
Photo 17

Inclined Crack on Roof of Varanda No.2, Ground Floor
Approx. Width = 1mm, Approx. Length = 2m.

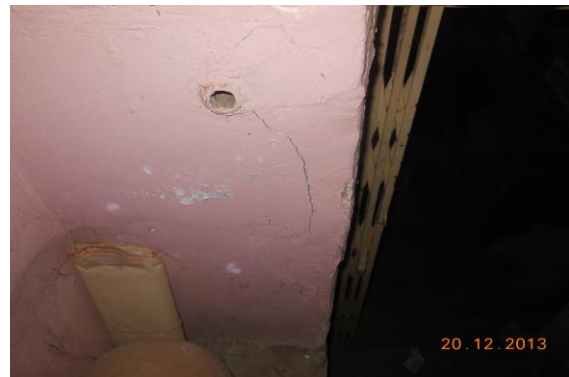
Photo 18

Inclined Crack on Wall No. 1 of Lobby no.2, Ground Floor
Approx. Width = 1.5mm, Approx. Length = 0.2m.
Distance from Wall No.4 = 2.5m, Height from Floor = 0.3m.

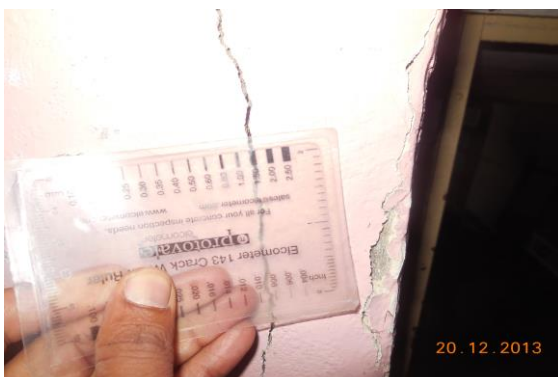
Photo 18A

Inclined Crack on Wall No. 1 of Lobby no.2, Ground Floor
Approx. Width = 1.5mm, Approx. Length = 0.2m.
Distance from Wall No.4 = 2.5m, Height from Floor = 0.3m.

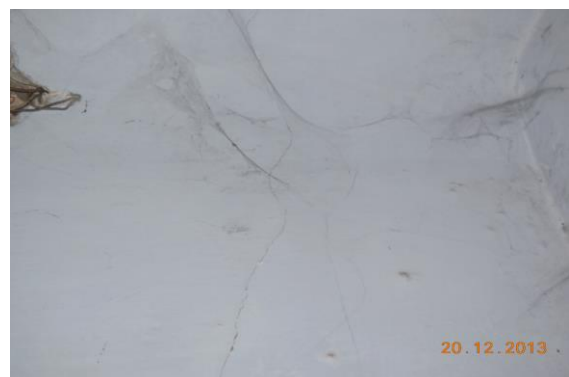
Photo 19

Inclined Crack on Wall No. 3 & Roof of Passage , Ground Floor
Approx. Width = 0.4mm, Approx. Length = 2.5m.
Distance from Wall No.1 = 0.4m, Height from Floor = 2m.

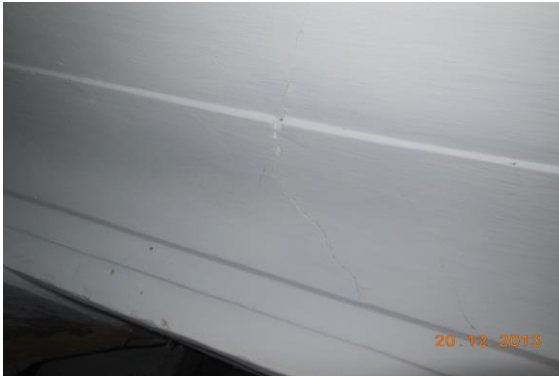
Photo 20
Inclined Crack on Roof of Hall No. 1, Basement
Approx. Width = 0.6mm, Approx. Length = 1m.

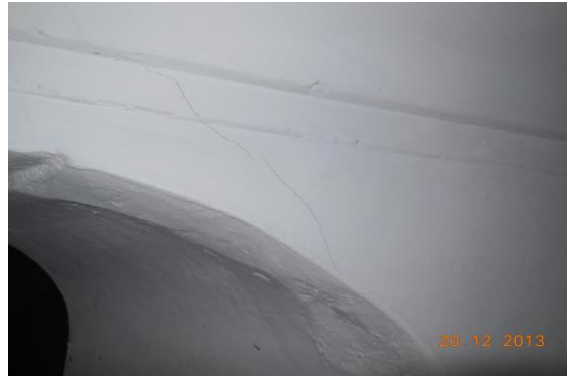
Photo 21
Inclined Crack on Wall No. 3 of Hall No. 1, Basement
Approx. Width = 0.6mm, Approx. Length = 1m.

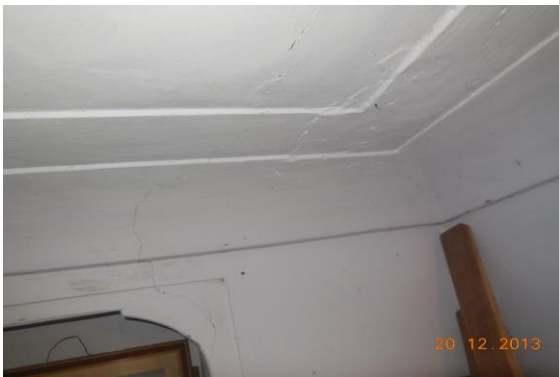
Photo 22
Inclined Crack on Wall No. 2 & Roof of Hall No. 2, Basement
Approx. Width = 0.25mm, Approx. Length = 1.6m.
Distance from Wall no.4 = 0.4m, Height from Floor = 1.5m.

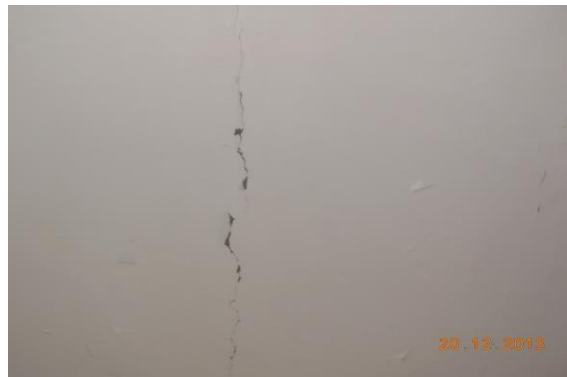
Photo 23
Inclined Crack on Room No. 1, First Floor
Approx. Width = 1mm, Approx. Length = 2m.

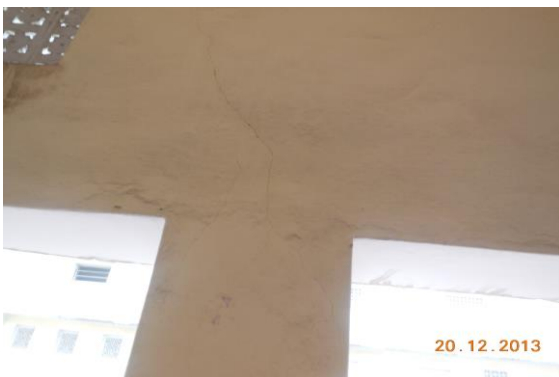
Photo 24
Inclined Crack on Wall No. 4 of Room No. 1, First Floor
Approx. Width = 0.5mm, Approx. Length = 1m.
Distance from Wall no.2 = 3m, Height from Floor = 1.6m.

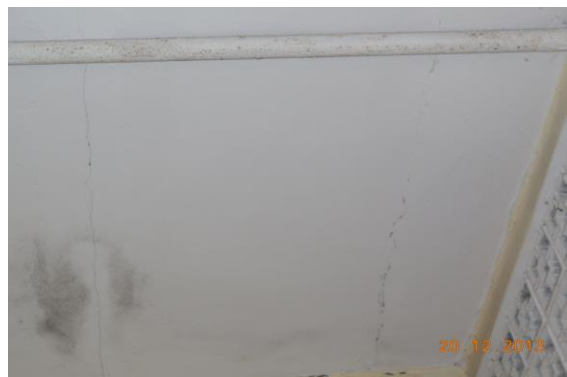
Photo 25
Inclined Crack on Roof of Room No. 1, First Floor
Approx. Width = 0.8mm, Approx. Length = 2m.

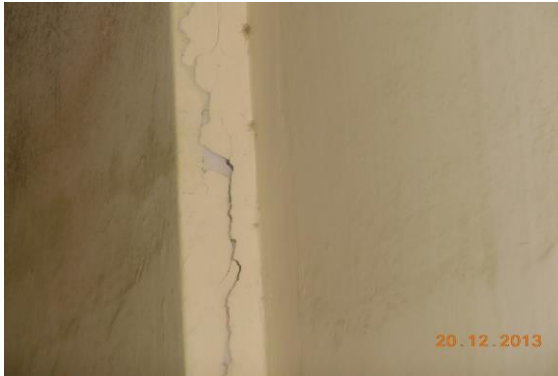
Photo 26

Inclined Crack on Wall No. 2 of Room No. 2, First Floor
Approx. Width = 1mm, Approx. Length = 1m.

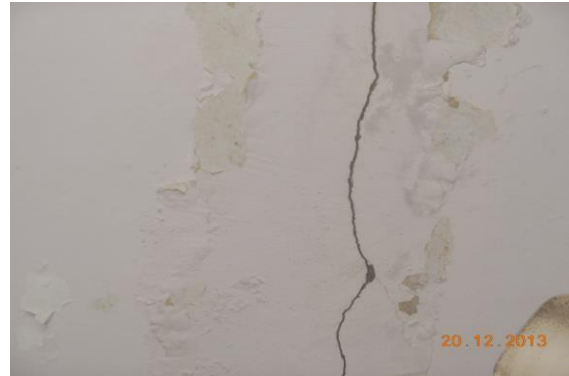
Photo 27

Inclined Crack on Roof of Room No. 2, First Floor
Approx. Width = 1.5mm, Approx. Length = 2m.

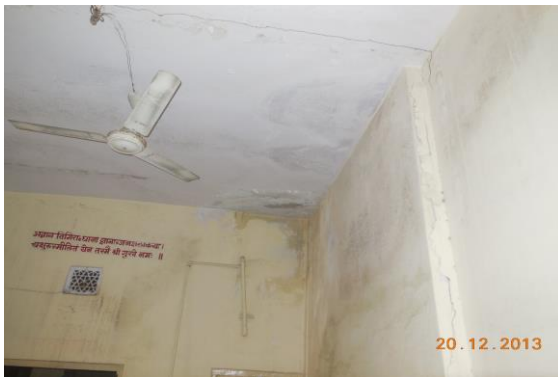
Photo 28

Inclined Crack on Roof & 2 of Room No. 2, First Floor
Approx. Width = 1mm, Approx. Length = 2m.

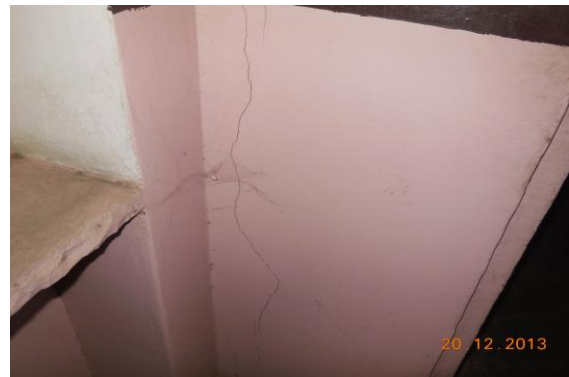
Photo 29

Inclined Crack on Wall No. 4 of Room No. 2, First Floor
Approx. Width = 1mm, Approx. Length = 1.8m.
Distance from Wall no.1 = 0.15m, Height from Floor = 0m.

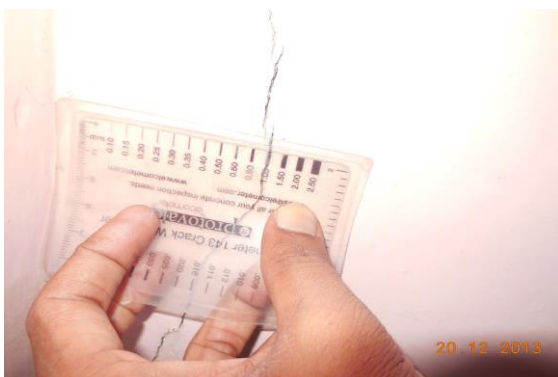
Photo 29A

Inclined Crack on Wall No. 4 of Room No. 2, First Floor
Approx. Width = 1mm, Approx. Length = 1.8m.
Distance from Wall no.1 = 0.15m, Height from Floor = 0m.

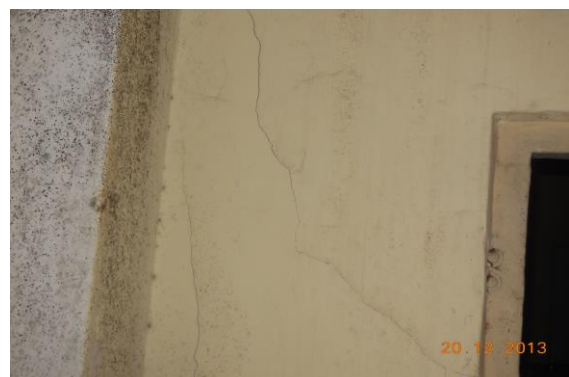
Photo 30

Inclined Crack on Wall No. 4 of Room No. 2, First Floor
Approx. Width = 0.35mm, Approx. Length = 2m.
Distance from = Corner Wall no.1 & 4m, Height from Floor = 1m.

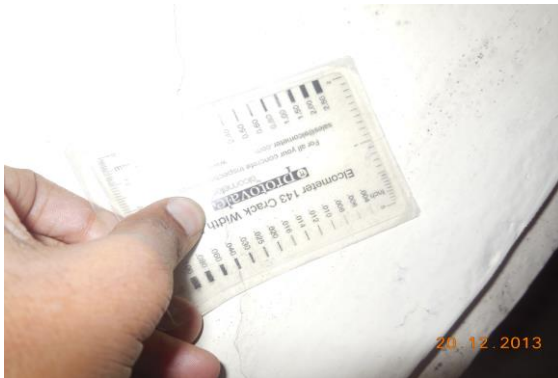
Photo 30A

Inclined Crack on Wall No. 4 of Room No. 2, First Floor
Approx. Width = 0.35mm, Approx. Length = 2m.
Distance from = Corner Wall no.1 & 4m, Height from Floor = 1m.

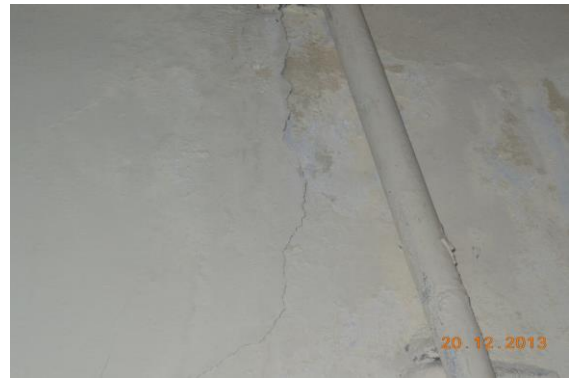
Photo 31

Vertical Crack on Wall No. 4 of Room No. 2, First Floor
Approx. Width = 0.5mm, Approx. Length = 1m.
Distance from Wall No.2 = 0.4m, Height from Floor = 2m.

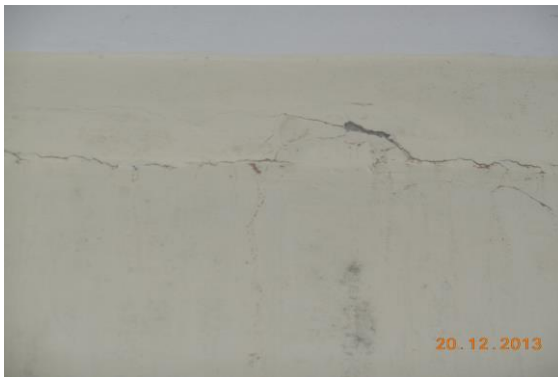
Photo 32

Inclined Crack on Wall No. 4 of Room No. 2, First Floor
Approx. Width = 1mm, Approx. Length = 2m.

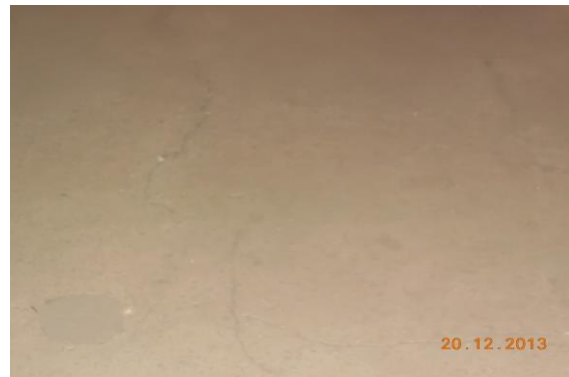
Photo 33

Inclined Crack on Floor of Hall No. 2, Part A of Hall. First Floor
Approx. Width = 0.3mm, Approx. Length = 1m.

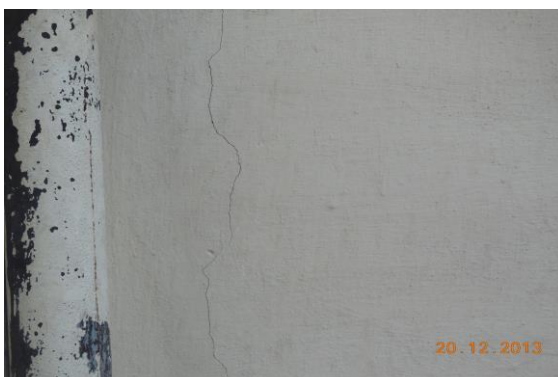
Photo 34

Inclined Crack on Wall No. 3 of Open sky, First Floor
Approx. Width = 0.35mm, Approx. Length = 0.7m.
Distance from Wall No.1 = 0m, Height from Floor = 0.5m.

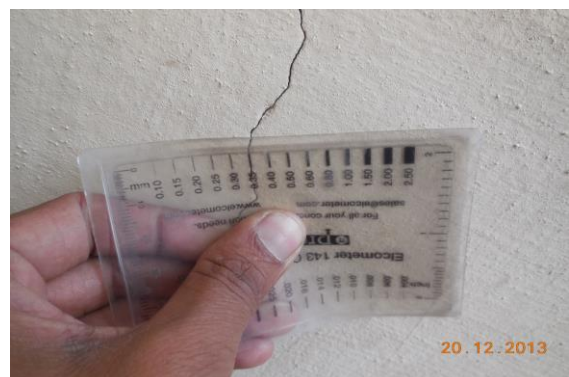
Photo 34A

Inclined Crack on Wall No. 3 of Open sky, First Floor
Approx. Width = 0.35mm, Approx. Length = 0.7m.
Distance from Wall No.1 = 0m, Height from Floor = 0.5m.

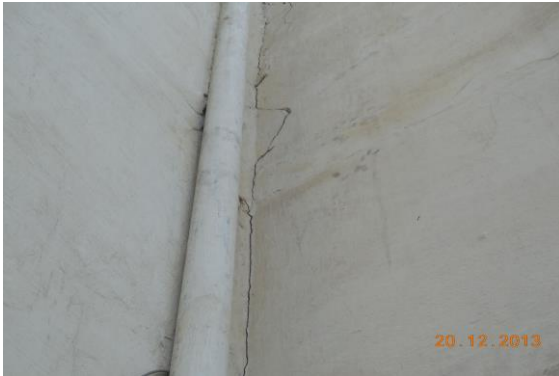
Photo 35

Vertical Crack on Wall No. 1 & 3 of Open Sky, First Floor
Approx. Width = 5mm, Approx. Length = 2.5m.
Distance from = Corner wall no.1 & 3m, Height from Floor = 1.6m.

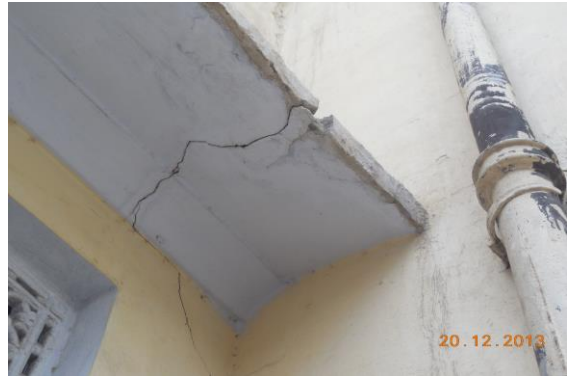
Photo 36

Inclined Crack on Wall No. 4 & Shade of Open Sky, First Floor
Approx. Width = 5mm, Approx. Length = 2m.

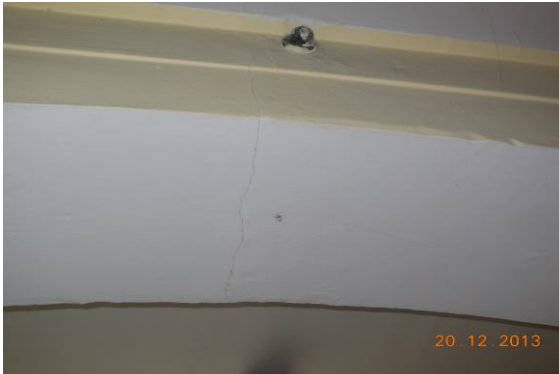
Photo 37

Horizontal Crack on Roof of Hall No. 3, Part A of Hall. First Floor
Approx. Width = 0.4mm, Approx. Length = 1m.
Distance from Wall no.1 = 4.5m, Height from Floor = 3m.

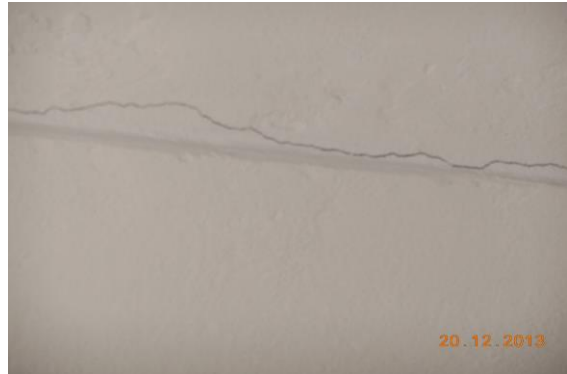
Photo 38

Inclined Crack on Roof of Hall No. 3, Part B of Hall. First Floor
Approx. Width = 0.8mm, Approx. Length = 2m.
Distance from Wall No.2 = 0m, Height from Floor = 3m.

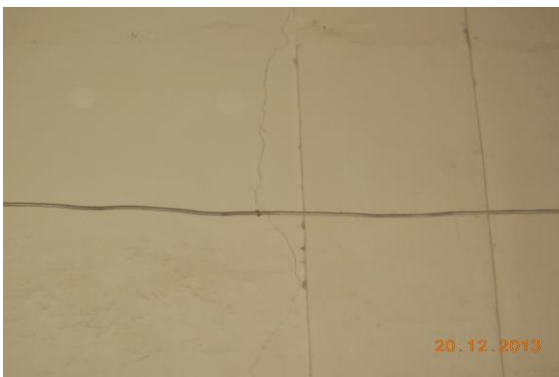
Photo 39

Inclined Crack on Wall No. 3 of Hall No. 3, Part A of Hall. First Floor
Approx. Width = 0.5mm, Approx. Length = 1.5m.
Distance from Wall No.2 = 3.5m, Height from Floor = 1m.

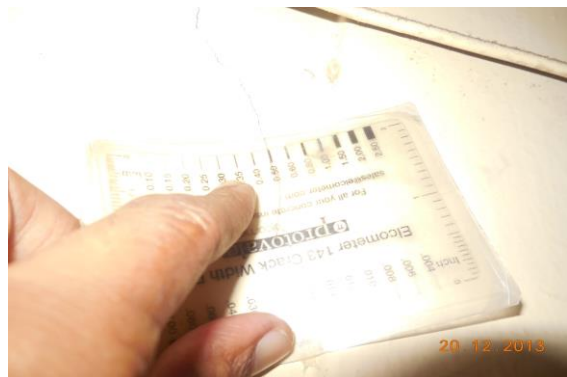
Photo 39A

Inclined Crack on Wall No. 3 of Hall No. 3, Part A of Hall. First Floor
Approx. Width = 0.5mm, Approx. Length = 1.5m.
Distance from Wall No.2 = 3.5m, Height from Floor = 1m.

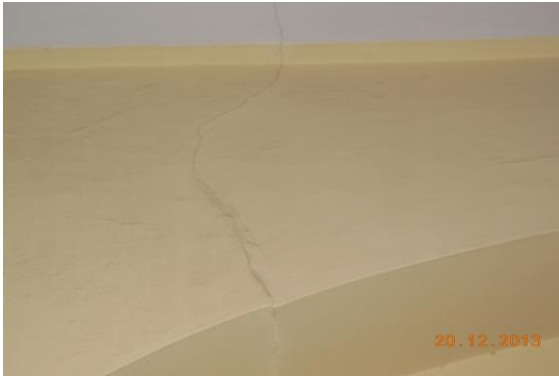
Photo 40

Inclined Crack on Roof of Hall No. 3, Part A of Hall. First Floor
Approx. Width = 0.5mm, Approx. Length = 1.5m.
Distance from Wall No.2 = 2.5m, Height from Floor = 2.5m.

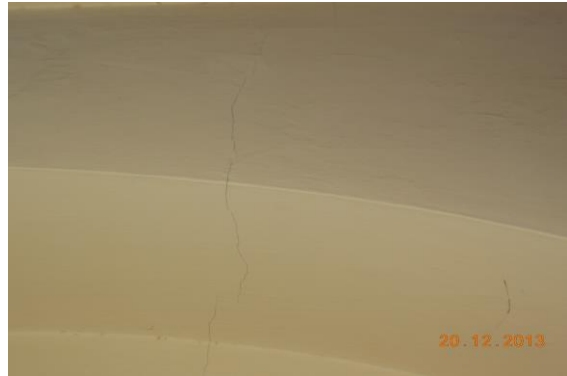
Photo 41

Inclined Crack on Wall No. 4 of Hall No. 3, Part A of Hall. First Floor
Approx. Width = 0.2mm, Approx. Length = 0.5m.
Distance from Wall No.2 = 1.5m, Height from Floor = 2.5m.

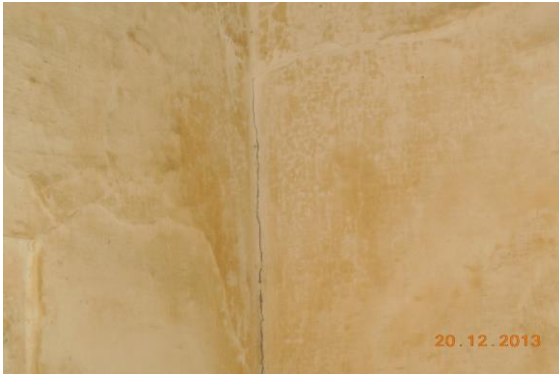
Photo 42

Inclined Crack on Wall No. 1, 3 & Roof of Passage No.1, First Floor
Approx. Width = 1mm, Approx. Length = 3m.
