Pre Building Condition Survey Report

Name and Address of Structure :	Choti Chopar to Badi Chopar (Down Line)
---------------------------------	---

Name of the Project	Contract JMRC-UG1B “Design and Construction of Tunnel between Chandpole and Badi Chouper and reverse line by Shield TBM, Underground Metro Stations at Choti Chouper and Badi Chouper by Cut and Cover Methods on East West Corridor of Jaipur Metro Rail Corporation Limited .”	
Owner :

Pre Building Condition Survey Report Choti Chopar to Badi Chopar (Down Line)

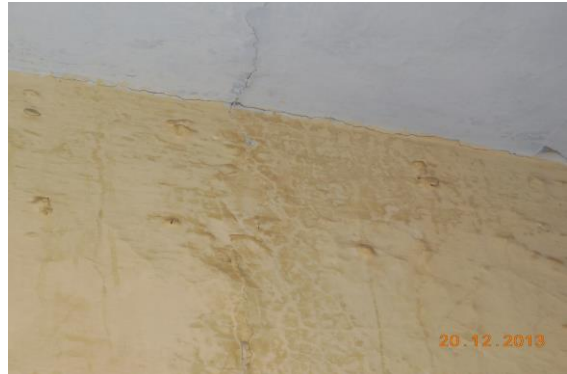
Photo 43

Inclined Crack on Wall No. 3 & Roof of Passage No.1, First Floor
Approx. Width = 1mm, Approx. Length = 2m.

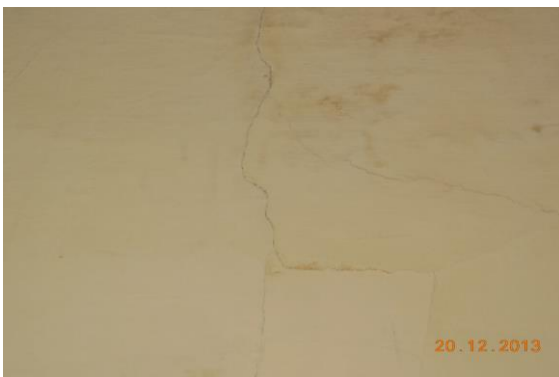
Photo 44

Inclined Crack on Wall No. 3 & Roof of Passage No.1, First Floor
Approx. Width = 1mm, Approx. Length = 2m.

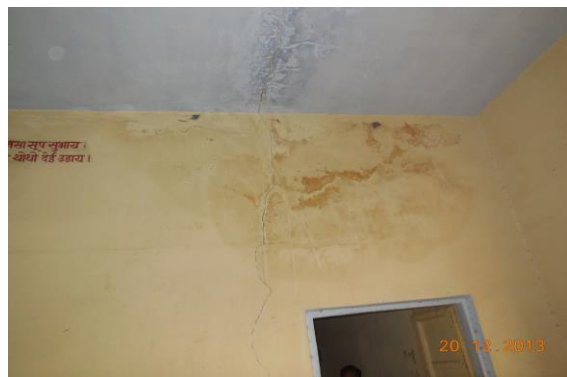
Photo 45

Inclined Crack on Wall No. 3 & Roof of Hall No. 1, First Floor
Approx. Width = 5mm, Approx. Length = 3m.
Distance from Wall No.1 = 1.5m, Height from Floor = 0m.

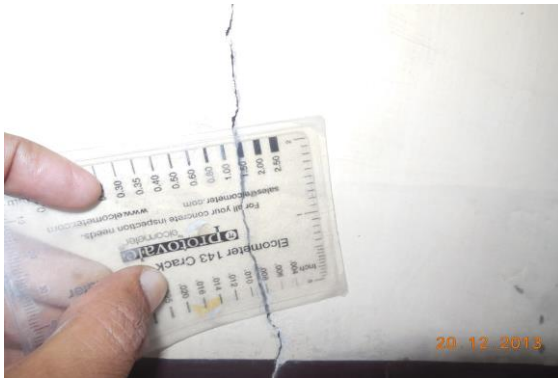
Photo 45A

Inclined Crack on Wall No. 3 & Roof of Hall No. 1, First Floor
Approx. Width = 5mm, Approx. Length = 3m.
Distance from Wall No.1 = 1.5m, Height from Floor = 0m.

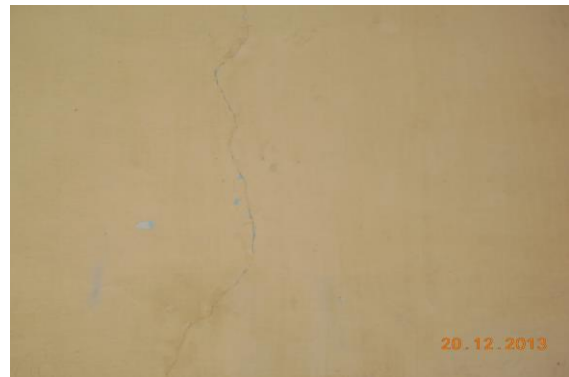
Photo 48

Inclined Crack on Wall No. 2 of Hall No. 1, First Floor
Approx. Width = 2mm, Approx. Length = 2m.
Distance from Wall no.1 = 1.5m, Height from Floor = 1.5m.

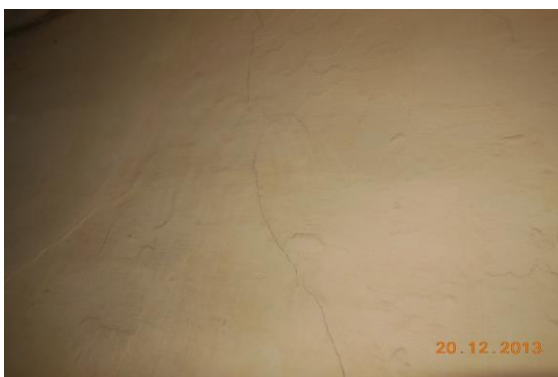
Photo 49

Inclined Crack on Wall No. 1 of Passage No.2, First Floor
Approx. Width = 0.6mm, Approx. Length = 1m.
Distance from Wall No.3 = 3m, Height from Floor = 0.8m.

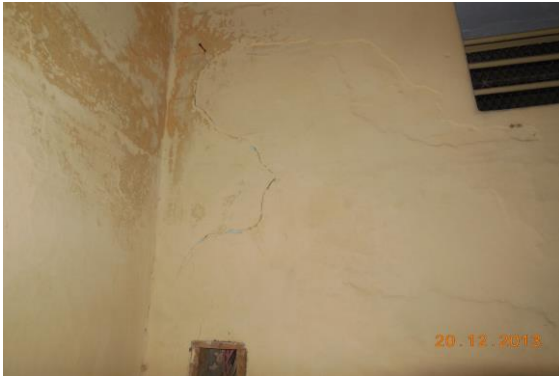
Photo 50

Inclined Crack on Wall No. 1 of Room No. 5, First Floor
Approx. Width = 0.3mm, Approx. Length = 0.3m.
Distance from Wall No.3 = 0.1m, Height from Floor = 1m.

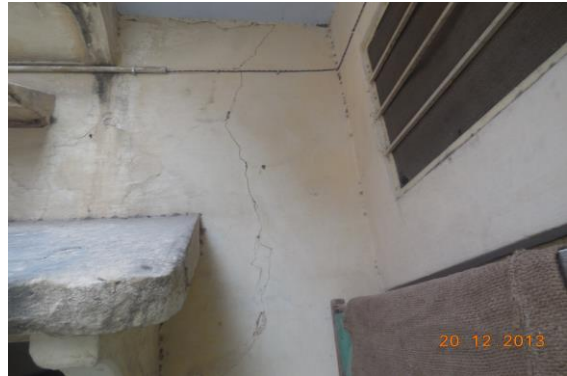
Photo 51

Inclined Crack on Wall No. 3 of Open sky No.2, First Floor
Approx. Width = 0.3mm, Approx. Length = 2.3m.
Distance from Wall no.1 = 0.4m, Height from Floor = 1.2m.

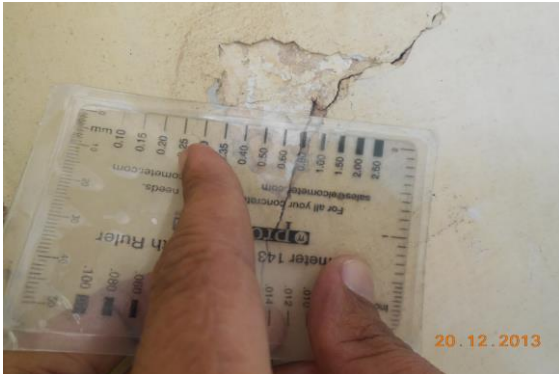
Photo 51A

Inclined Crack on Wall No. 3 of Open sky No.2, First Floor
Approx. Width = 0.3mm, Approx. Length = 2.3m.
Distance from Wall no.1 = 0.4m, Height from Floor = 1.2m.

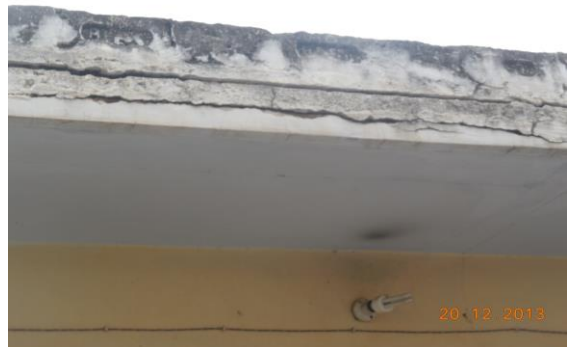
Photo 52

Inclined Crack on Wall No. 1 & Shade of Open sky No.2, First Floor
Approx. Width = 5mm, Approx. Length = 2m.

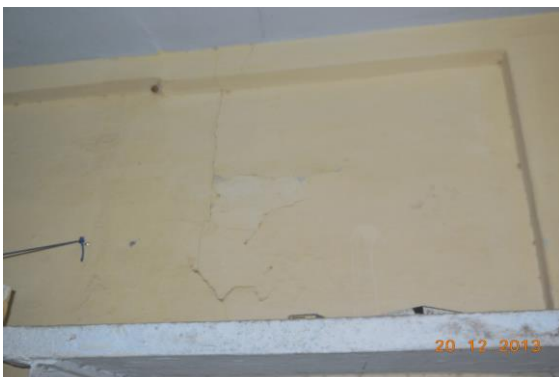
Photo 53

Inclined Crack on Wall No. 4 of Room No. 6, First Floor
Approx. Width = 0.5mm, Approx. Length = 1m.

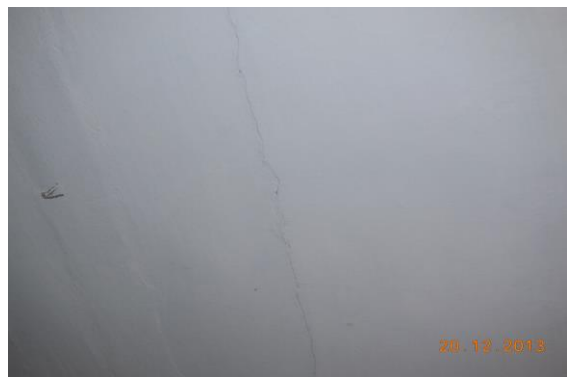
Photo 54

Inclined Crack on Roof of Room No. 6, First Floor
Approx. Width = 0.5mm, Approx. Length = 1m.

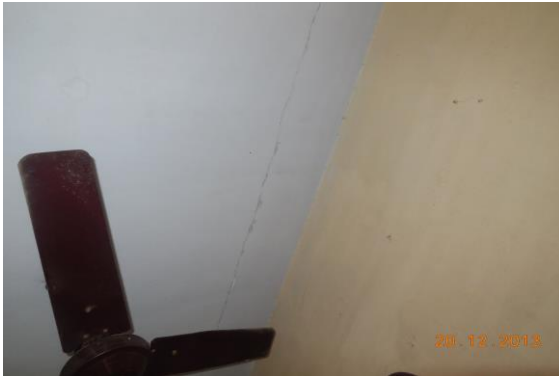
Photo 55
Inclined Crack on Roof of Room No. 7, First Floor
Approx. Width = 0.5mm, Approx. Length = 3m.

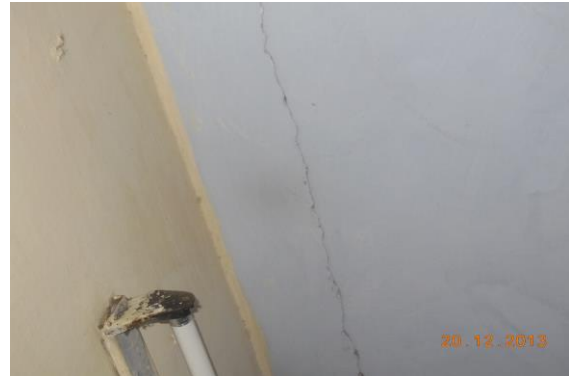
Photo 56
Inclined Crack on Roof of Room No. 8, First Floor
Approx. Width = 0.5mm, Approx. Length = 3m.

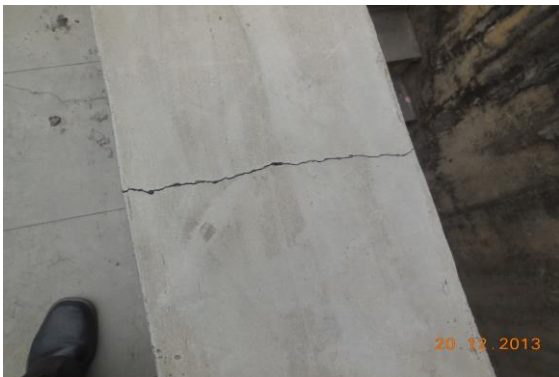
Photo 57
Inclined Crack on Perapet wall of Staircase, Second Floor
Approx. Width = 1mm, Approx. Length = 1m.

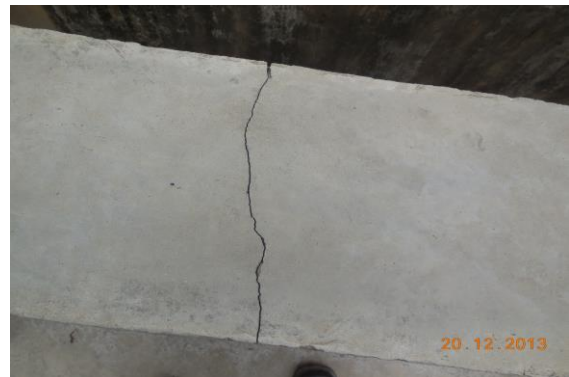
Photo 58
Inclined Crack on Perapet wall No.2 of Staircase, Second Floor
Approx. Width = 1mm, Approx. Length = 1m.

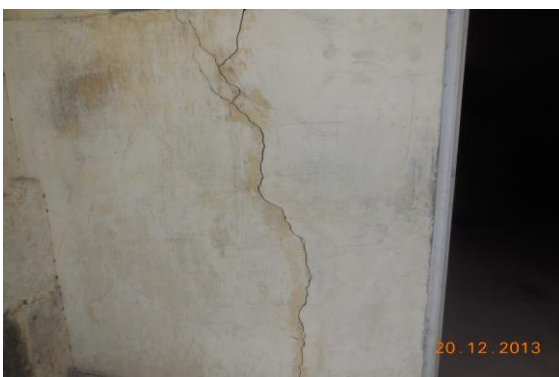
Photo 59
Inclined Crack on Wall No. 3 of Open Sky, Second Floor
Approx. Width = 2.5mm, Approx. Length = 2m.
Distance from Wall no.2 = 2.5m, Height from Floor = 0m.

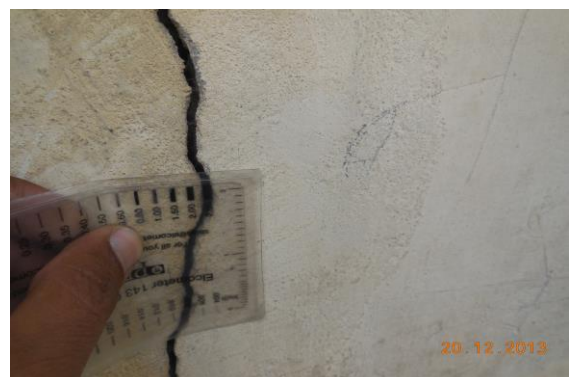
Photo 59A
Inclined Crack on Wall No. 3 of Open Sky, Second Floor
Approx. Width = 2.5mm, Approx. Length = 2m.
Distance from Wall no.2 = 2.5m, Height from Floor = 0m.

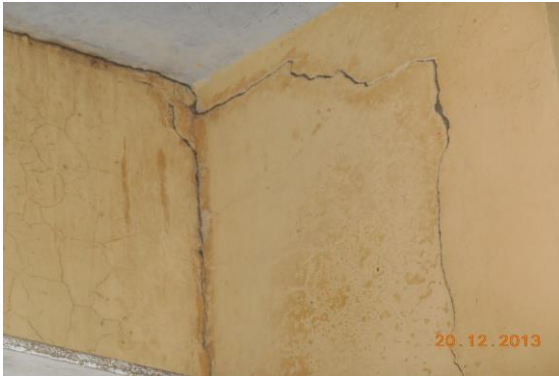
Photo 60

Inclined Crack on Wall No. 1 of Hall No. 1, Second Floor
Approx. Width = 5mm, Approx. Length = 3m.

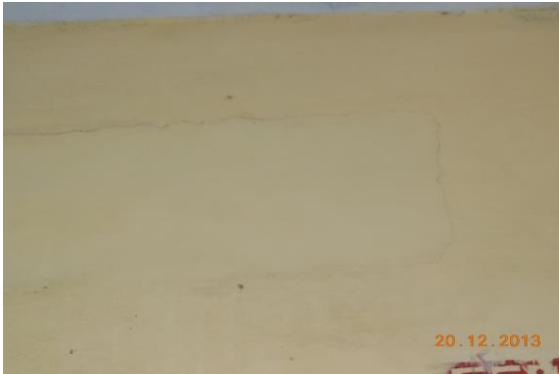
Photo 62

Inclined Crack on Wall No. 3 of Hall No. 1, Second Floor
Approx. Width = 0.5mm, Approx. Length = 2m.

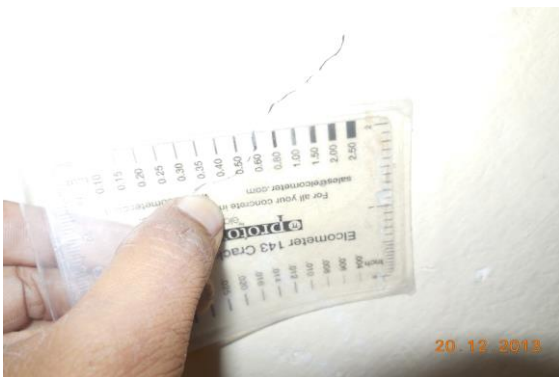
Photo 63A

Inclined Crack on Wall No. 2 of Hall No. 2, Second Floor
Approx. Width = 0.6mm, Approx. Length = 2.5m.
Distance from Wall no.4 = 3.3m, Height from Floor = 0m.

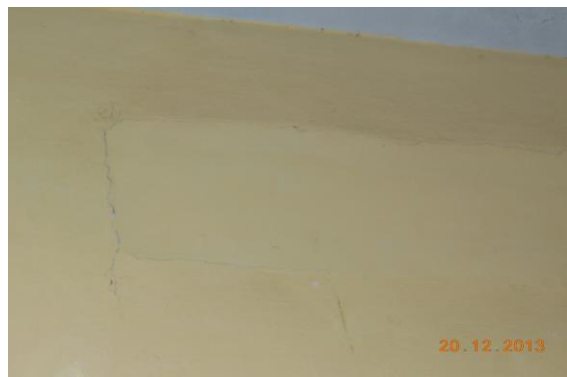
Photo 64

Inclined Crack on Wall No. 2 of Hall No. 2, Second Floor
Approx. Width = 0.6mm, Approx. Length = 1m.

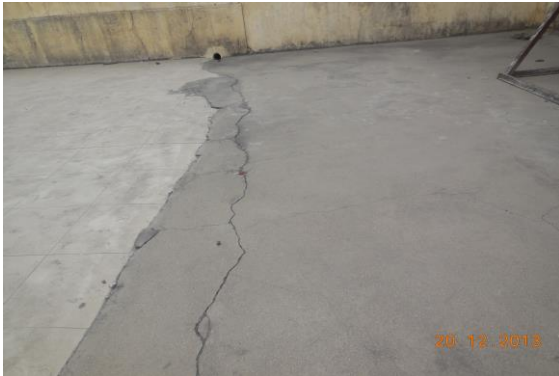
Photo 65

Inclined Crack on Floor of Open Sky, Second Floor
Approx. Width = 4mm, Approx. Length = 2m.

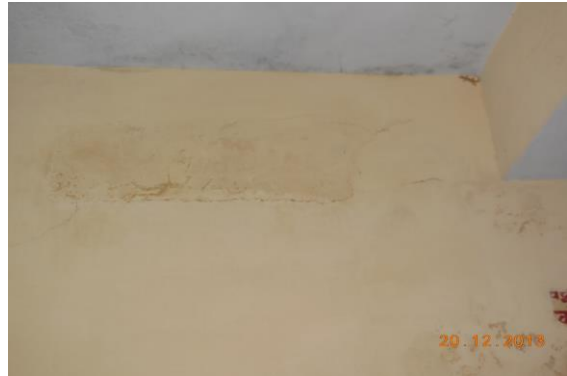
Photo 66

Inclined Crack on Wall No. 4 of Hall No. 3, Second Floor
Approx. Width = 0.5mm, Approx. Length = 1m.

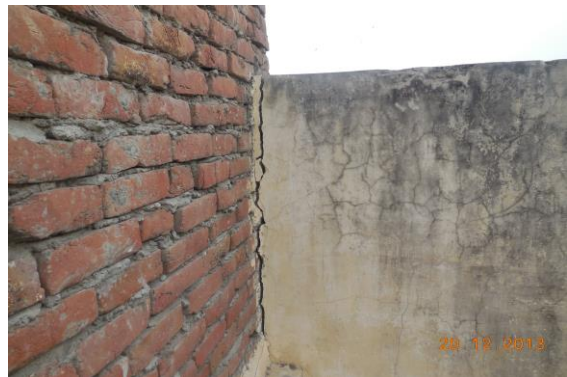
Photo 68

Inclined Crack on Wall No. 4 & 2 of Open Sky, Second Floor
Approx. Width = 5mm, Approx. Length = 1m.

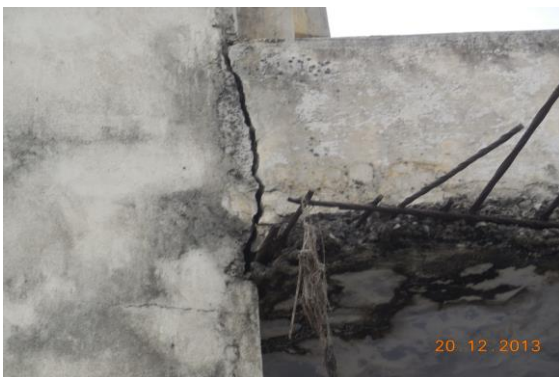
Photo 69

Inclined Crack on Wall No. 3 & Shade of Open Sky, Second Floor
Approx. Width = 7mm, Approx. Length = 1m.

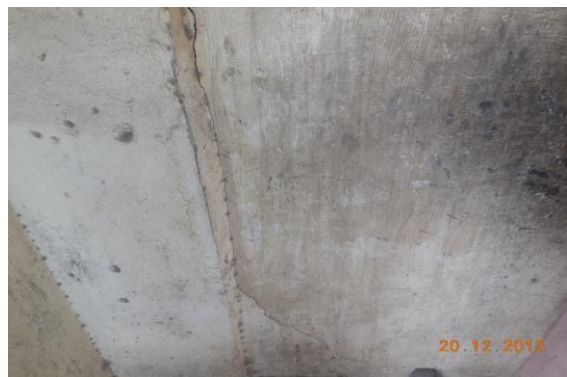
Photo 70

Vertical Crack on Staircase FF to SF, Second Floor
Approx. Width = 1mm, Approx. Length = 1.2m.
Distance from Wall no.2 = 0.3m, Height from Floor = 0m.

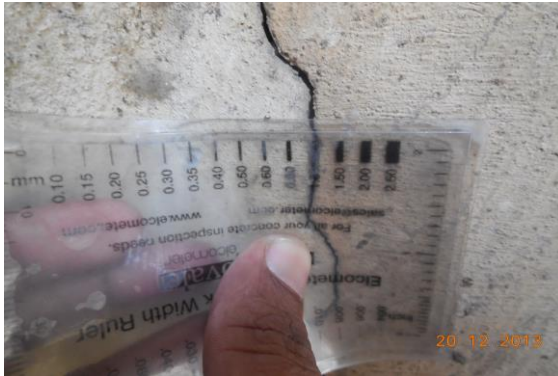
Photo 70A

Vertical Crack on Staircase FF to SF, Second Floor
Approx. Width = 1mm, Approx. Length = 1.2m.
Distance from Wall no.2 = 0.3m, Height from Floor = 0m.

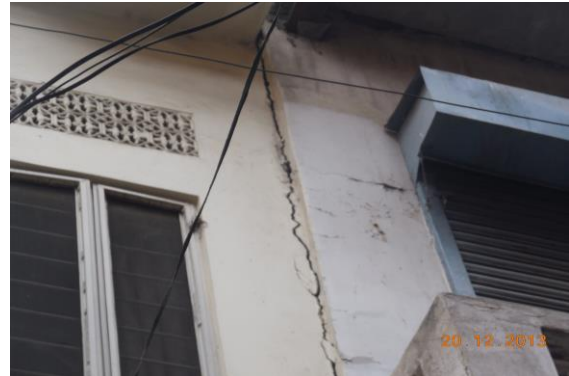
Photo 71

Inclined Crack on Outside Front Wall no.3 of Building, Ground Floor
Approx. Width = 10mm, Approx. Length = 3m.

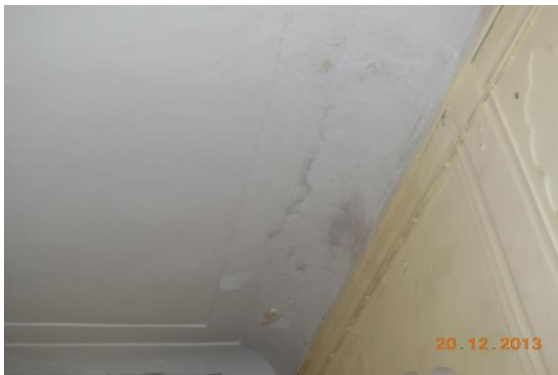
Photo 72

Dampness/Seepage on Roof of Varanda of Ground Floor

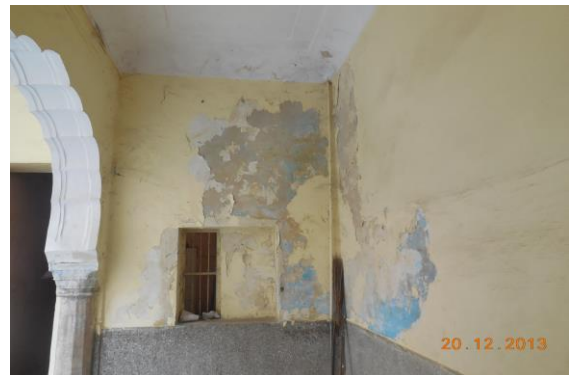
Photo 73

Dampness/Seepage on Wall No. 3 & 2 of Varanda of Ground Floor

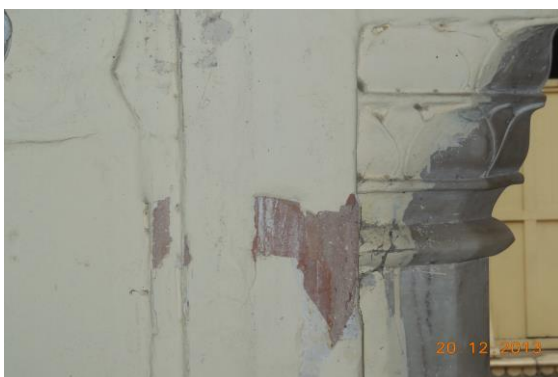
Photo 74

Damaged Portion on Wall No. 4 of Varanda of Ground Floor

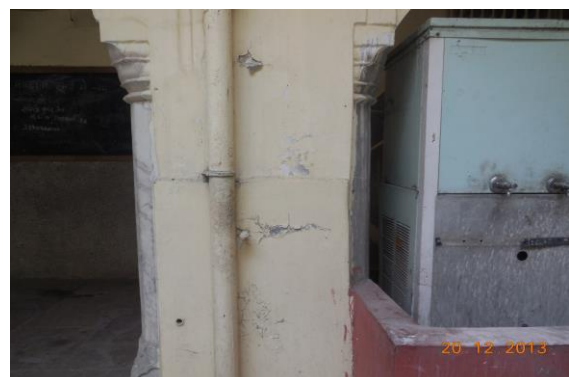
Photo 75

Peeling of Plaster on Wall No. 3 of Open sky of Ground Floor

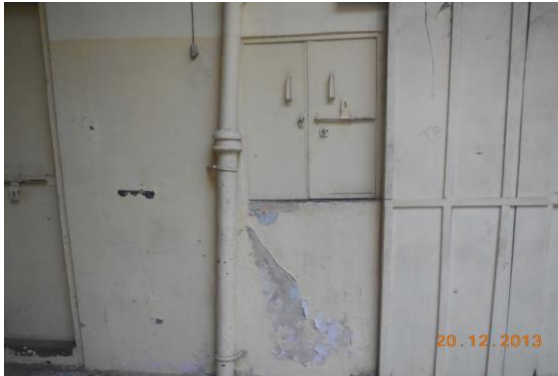
Photo 76
Peeling of Plaster on Wall No. 2 of Open sky of Ground Floor

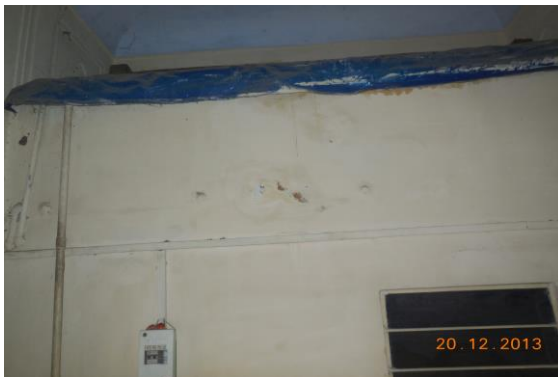
Photo 78
Peeling of Plaster on Wall No. 1 of Hall No. 1 of Ground Floor

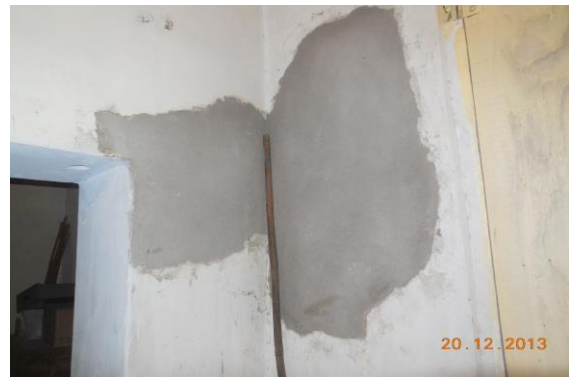
Photo 79
Damaged Portion on Wall No. 1 & 4 of Room No. 1 of Part A of Room. Ground Floor

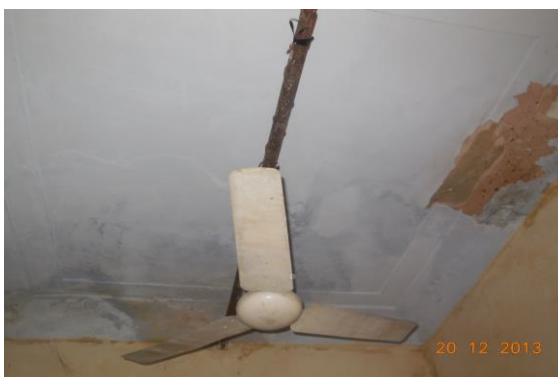
Photo 80
Dampness/Seepage on Roof of Room No. 1 of Part b of Room. Ground Floor

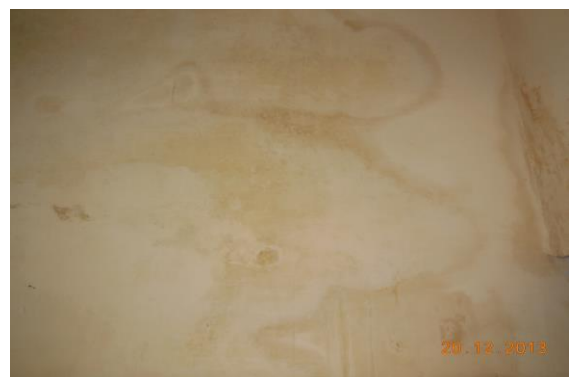
Photo 81
Dampness/Seepage on Wall No. 2 of Room No. 1 of Part b of Room. Ground Floor

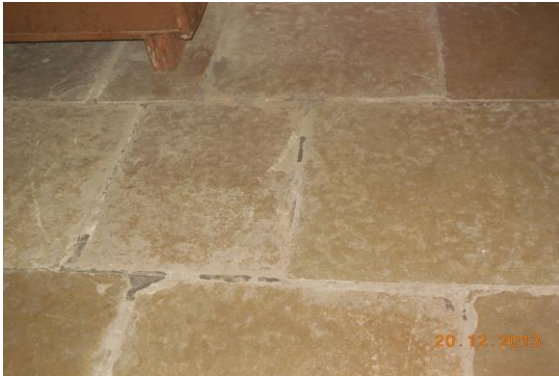
Photo 82
Damaged Portion on Floor of Hall No. 1 of Ground Floor

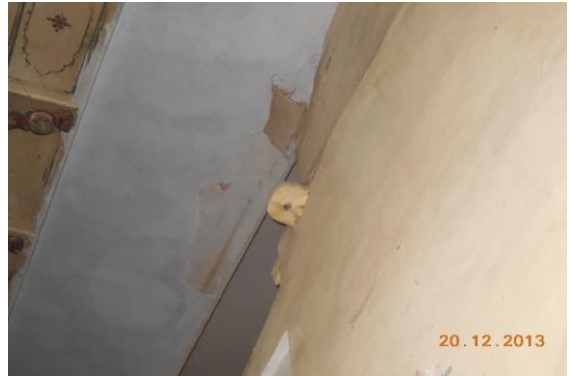
Photo 83
Peeling of Plaster on Roof of Varanda No.2 of Ground Floor

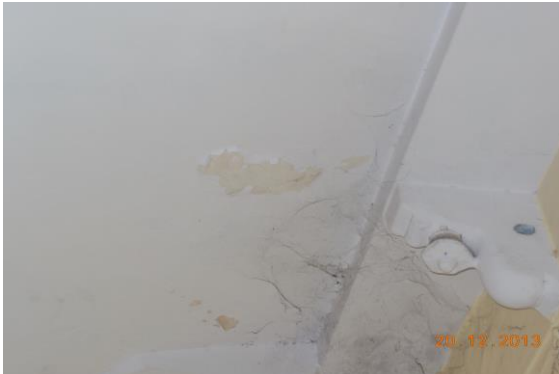
Photo 84
Damaged Portion on Shade of Varanda No.2 of Ground Floor

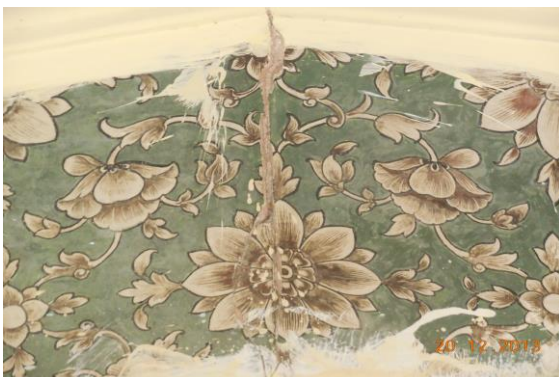
Photo 86
Peeling of Plaster on Wall No. 2 of Lobby No.1 of Ground Floor

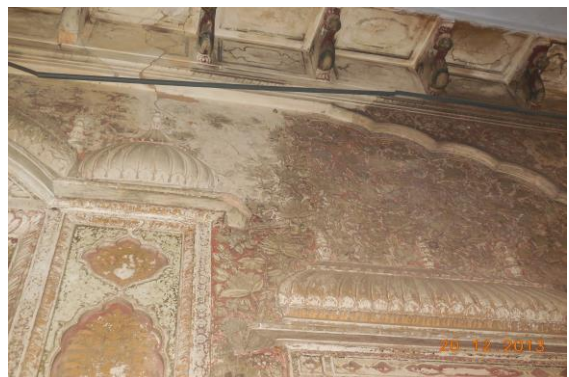
Photo 87
Peeling of Plaster on Frontside Wall of Temple of Ground Floor

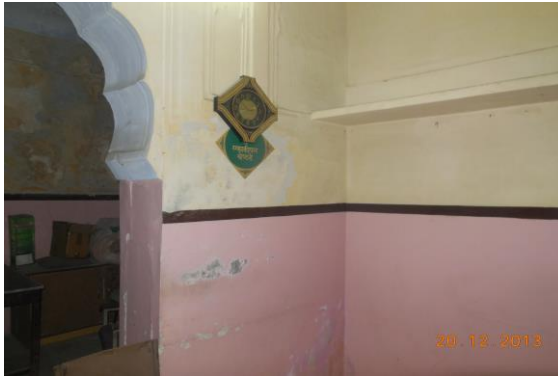
Photo 88

Dampness/Seepage on Wall No. 6 of Lobby no.2 of Ground Floor

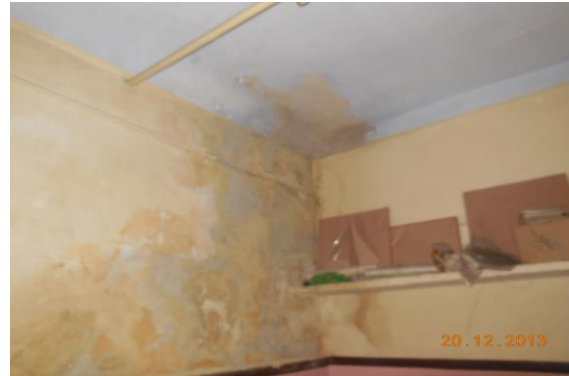
Photo 89

Dampness/Seepage on Wall No. 4 & Roof of Lobby no.2 of Ground Floor

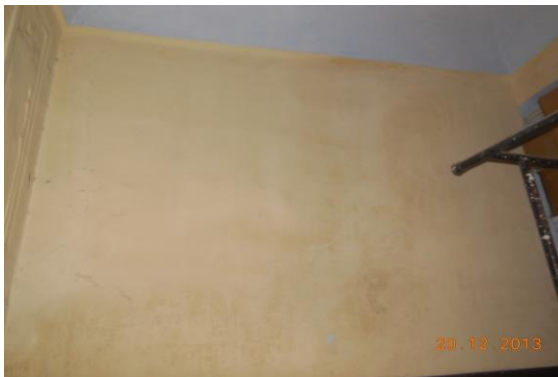
Photo 90

Dampness/Seepage on Wall No. 1 of Lobby no.2 of Ground Floor

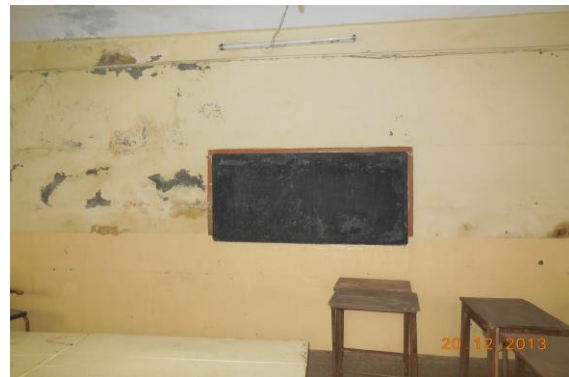
Photo 91

Dampness/Seepage on Wall No. 4 of Hall No. 2 of Ground Floor

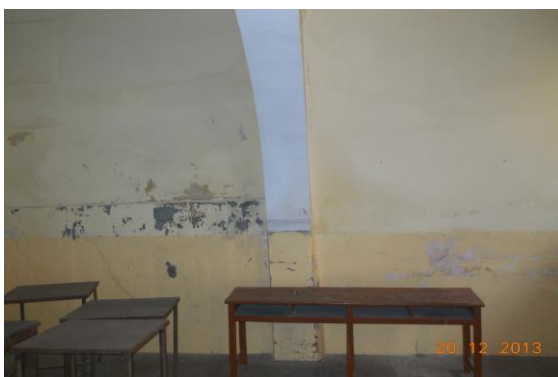
Photo 92

Dampness/Seepage on Wall No. 2 of Hall No. 2 of Ground Floor

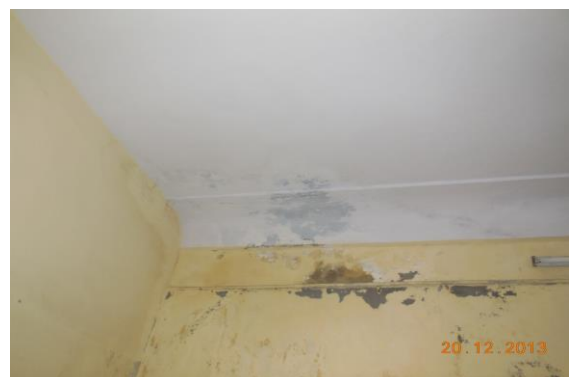
Photo 93

Dampness/Seepage on Roof of Hall No. 2 of Ground Floor

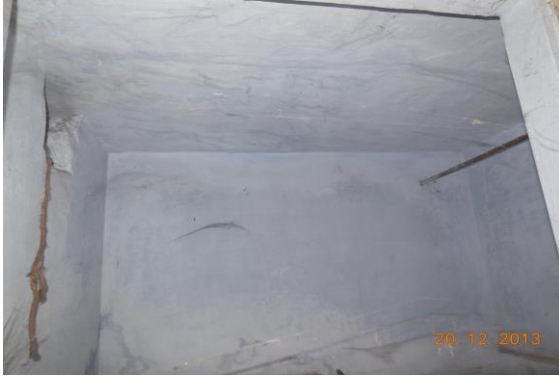
Photo 94

Dampness/Seepage on All Walls & Roof of Bathroom No. of Ground Floor

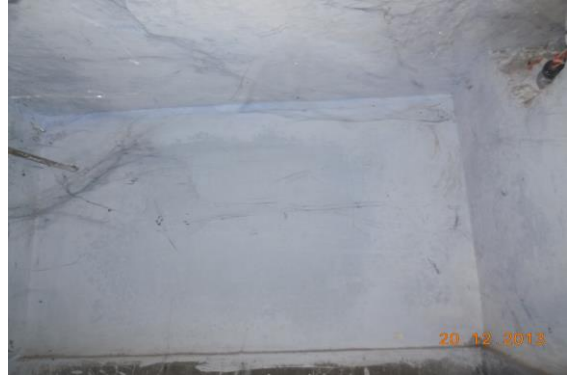
Photo 95

Dampness/Seepage on All Walls & Roof of Bathroom No. of Ground Floor

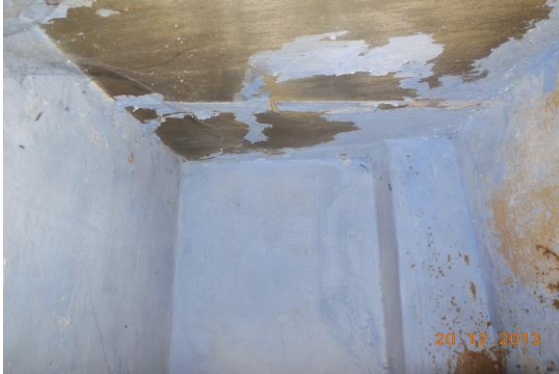
Photo 96

Dampness/Seepage on All Walls & Roof of Toilet No. 1 of Ground Floor

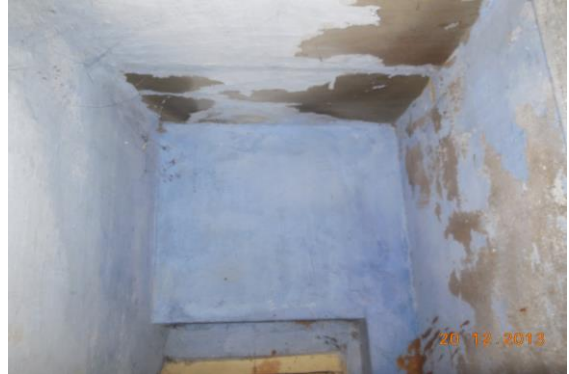
Photo 97

Dampness/Seepage on All Walls & Roof of Toilet No. 2 of Ground Floor

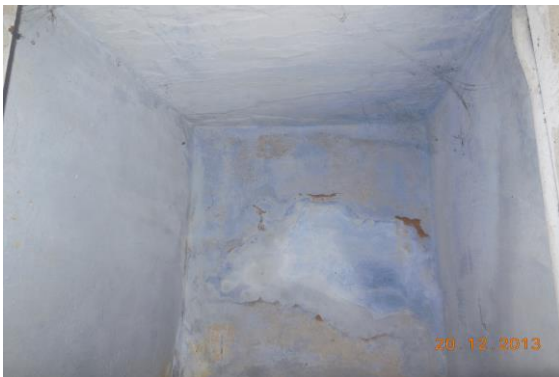
Photo 98

Dampness/Seepage on All Walls & Roof of Toilet No. 3 of Ground Floor

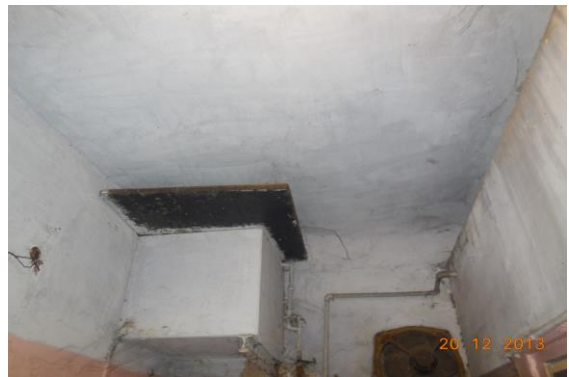
Photo 99

Dampness/Seepage on Wall No. 4 & Roof of Passage of Ground Floor

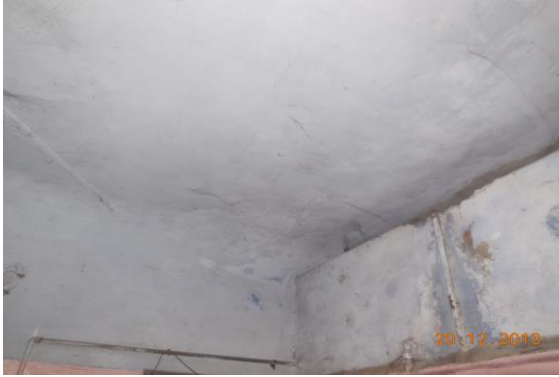
Photo 100
Dampness/Seepage on Roof of Passage of Ground Floor

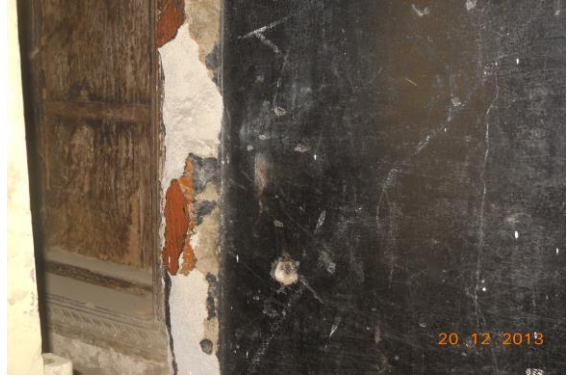
Photo 101
Damaged Portion on Frontside Wall No.3 of Temple of Ground Floor

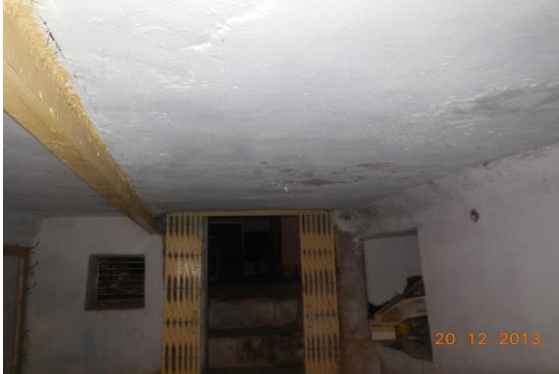
Photo 102
Dampness/Seepage on Roof of Passage of Basement

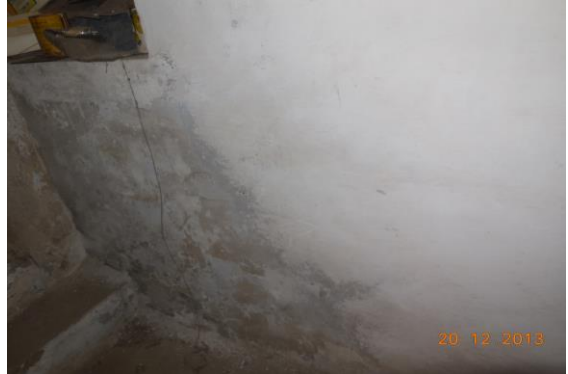
Photo 103
Dampness/Seepage on Wall No. 1 of Passage of Basement

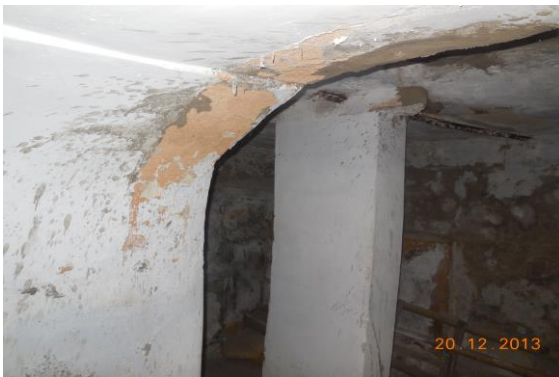
Photo 104
Dampness/Seepage on Outside Wall no.3 of Hall No. 6 of Basement

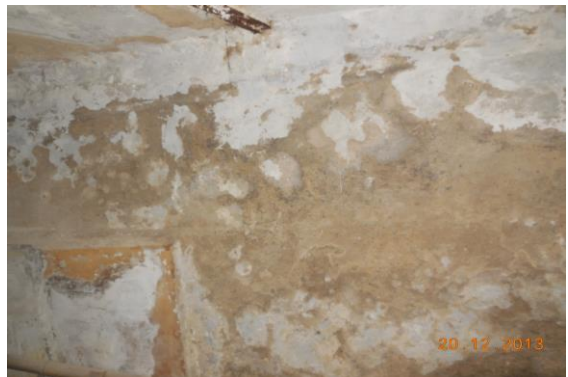
Photo 105
Peeling of Plaster on Wall No. 4 of Hall No. 6 of Basement

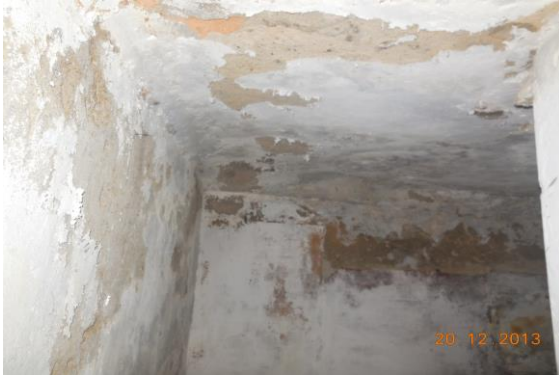
Photo 106

Dampness/Seepage on Wall No. 1, 3 & Roof of Hall No. 6 of Basement

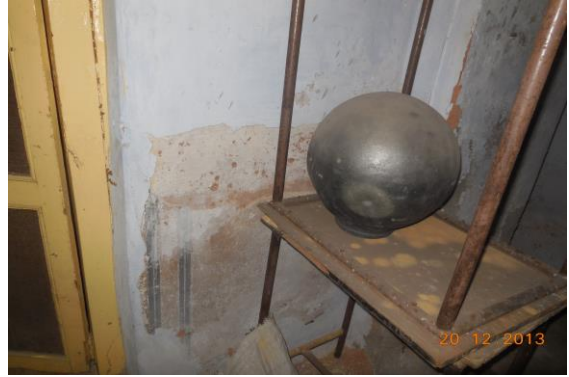
Photo 107

Peeling of Plaster on Wall No. 1 of Hall No. 1 of Basement

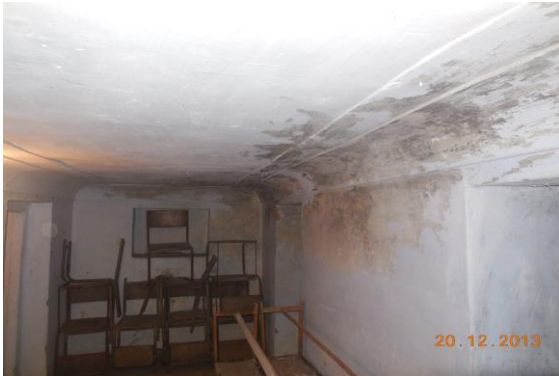
Photo 108

Dampness/Seepage on Wall No. 1, 4 & Roof of Hall No. 4 of Part A of Hall, Basement

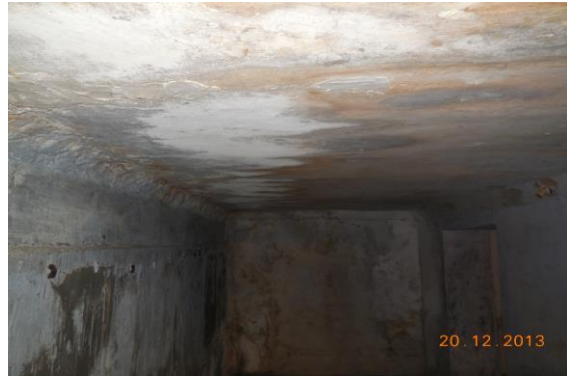
Photo 109

Dampness/Seepage on Wall No. 2, 4 & Roof of Part B of Hall of Basement

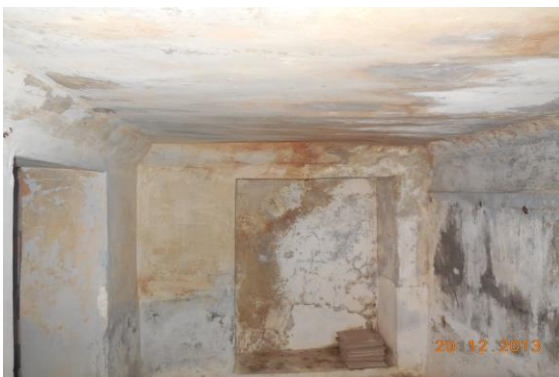
Photo 110

Dampness/Seepage on Wall No. 1, 3, 4 & Roof of Part B of Hall of Basement

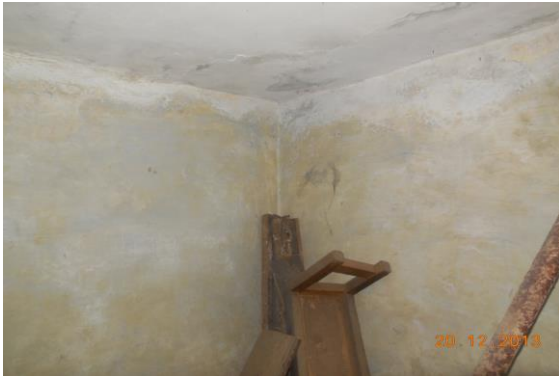
Photo 112

Dampness/Seepage on Wall No. 2, 4 & Roof of Hall No. 5 of Basement

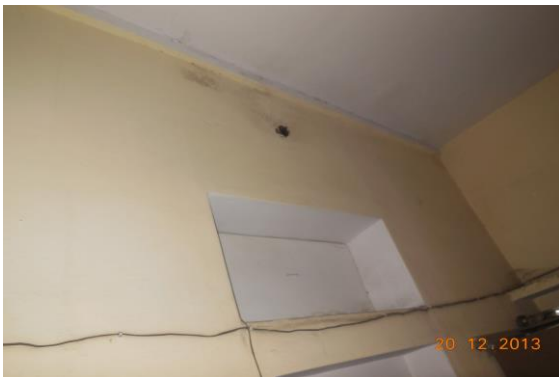
Photo 114

Dampness/Seepage on Wall No. 3 of Room No. 1 of First Floor

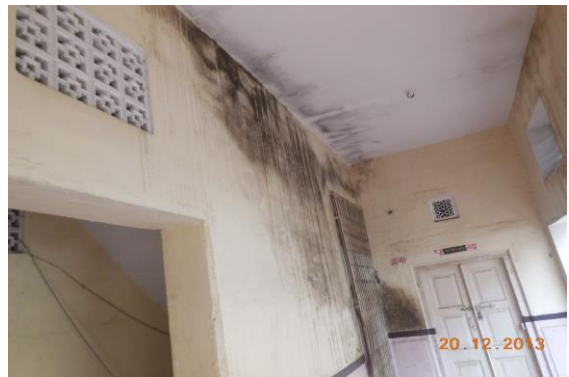
Photo 115

Dampness/Seepage on Wall No. 3 of Room No. 1 of First Floor

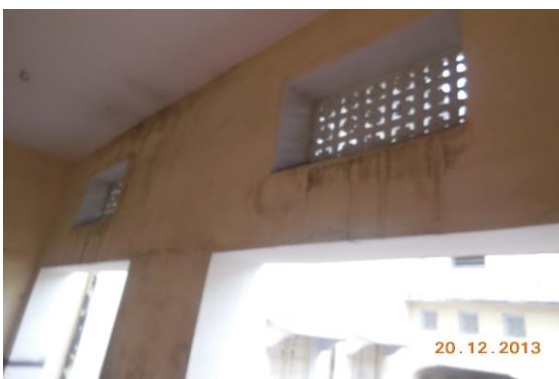
Photo 116

Dampness/Seepage on Wall No. 4 of Room No. 1 of First Floor

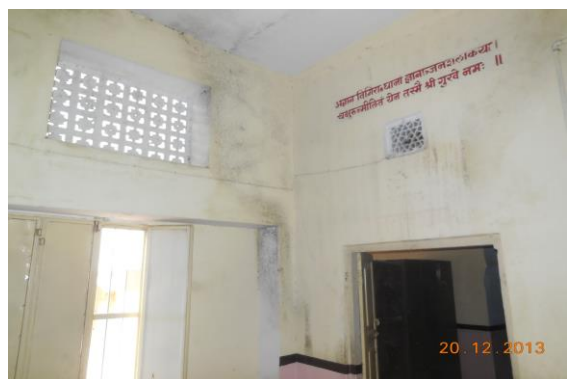
Photo 117

Dampness/Seepage on Wall No. 1 & 4 of Room No. 2 of First Floor

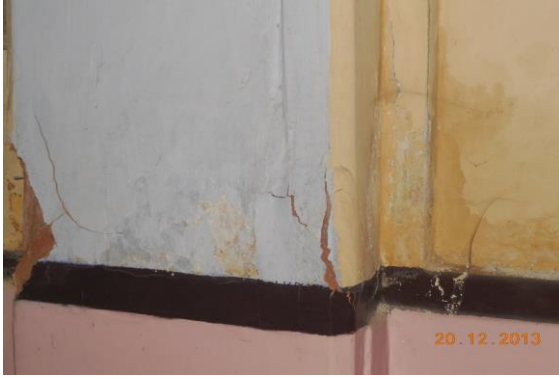
Photo 118

Damaged Portion on Wall No. 2 of Hall No. 2 of Part A of Hall. First Floor

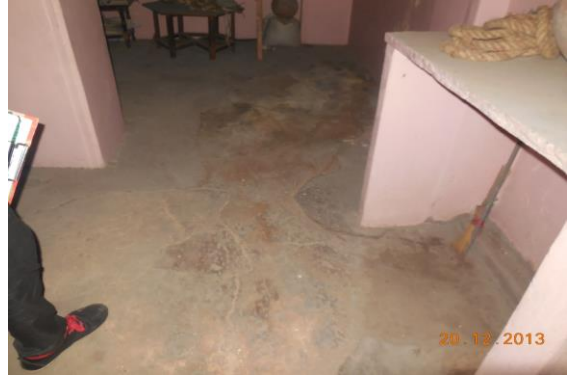
Photo 119

Peeling of Plaster on Floor of Hall No. 2 of Part A of Hall. First Floor

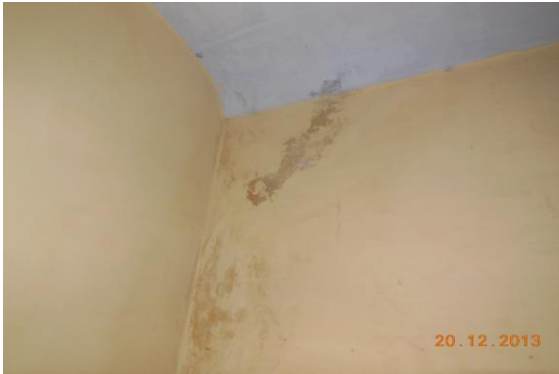
Photo 120

Dampness/Seepage on Wall No. 4 of Room No. 3 of First Floor

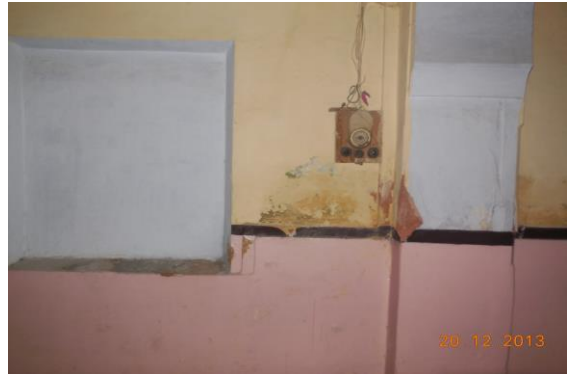
Photo 121

Peeling of Plaster on Wall No. 1 of Room No. 3 of First Floor

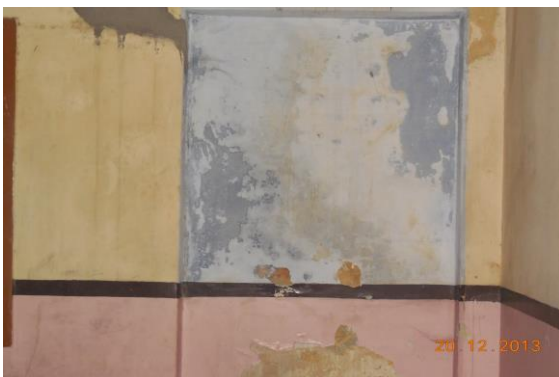
Photo 122

Dampness/Seepage on Wall No. 4 of Hall No. 2 of Part B of Hall. First Floor

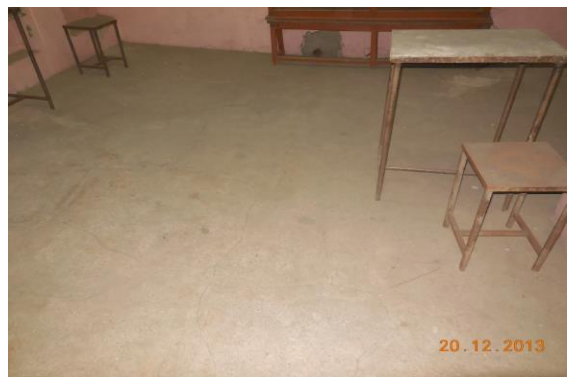
Photo 123

Peeling of Plaster on Floor of Hall No. 2 of Part B of Hall. First Floor

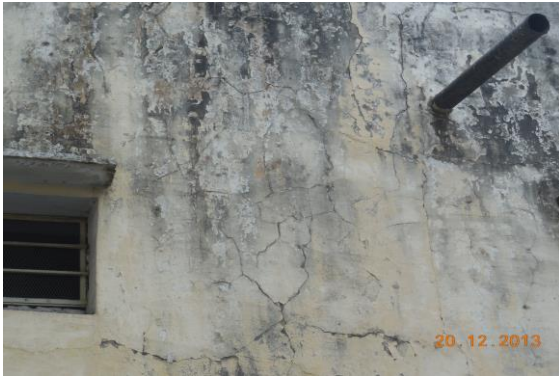
Photo 124
Peeling of Plaster on Wall No. 4 of Open Sky of First Floor

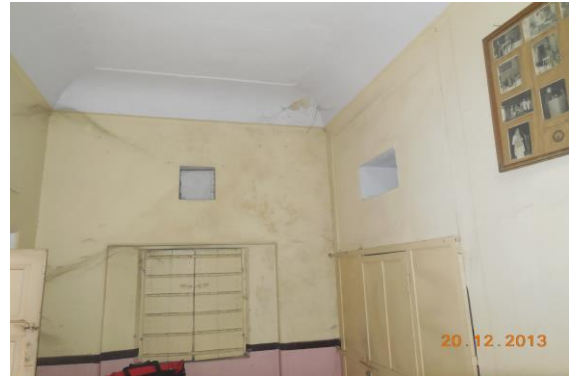
Photo 125
Dampness/Seepage on Wall No. 1 & Roof of Hall No. 3 of Part A of Hall. First Floor

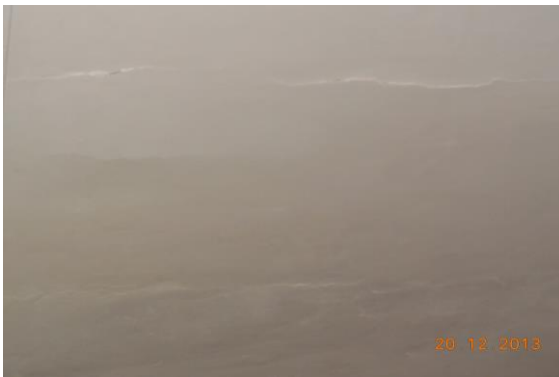
Photo 126
Peeling of Plaster on Roof of Hall No. 3 of Part B of Hall. First Floor

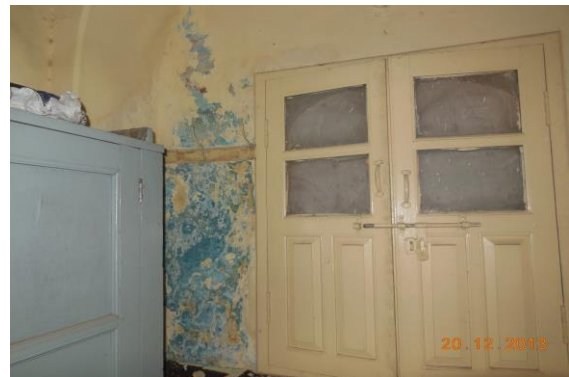
Photo 127
Peeling of Plaster on Wall No. 4 of Hall No. 3 of Part B of Hall. First Floor

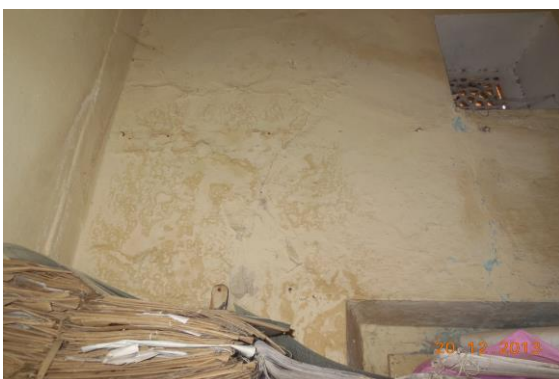
Photo 128
Dampness/Seepage on Wall No. 1 of Hall No. 3 of Part C of Hall. First Floor

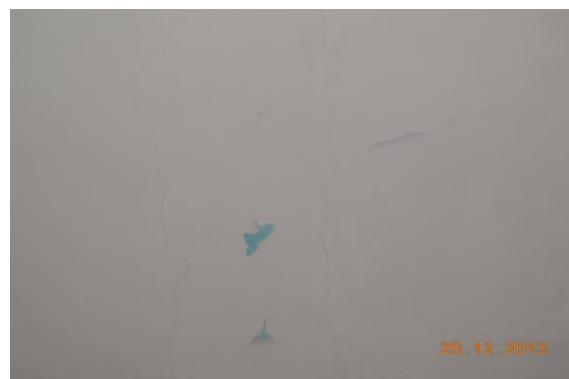
Photo 129
Peeling of Plaster on Roof of Hall No. 3 of Part A of Hall. First Floor

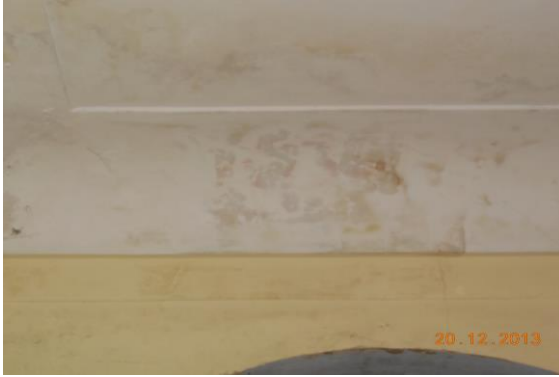
Photo 130
Dampness/Seepage on Roof of Hall No. 3 of Part A of Hall. First Floor

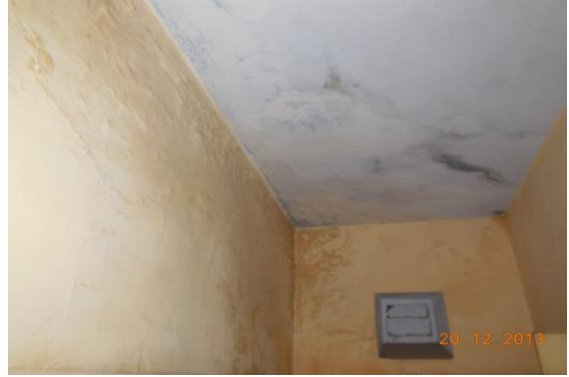
Photo 131
Dampness/Seepage on Wall No. 1, 3 & Roof of Passage No.1 of First Floor

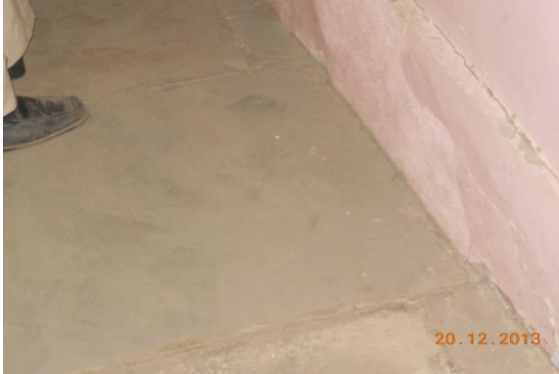
Photo 132
Peeling of Plaster on Floor of Passage No.1 of First Floor

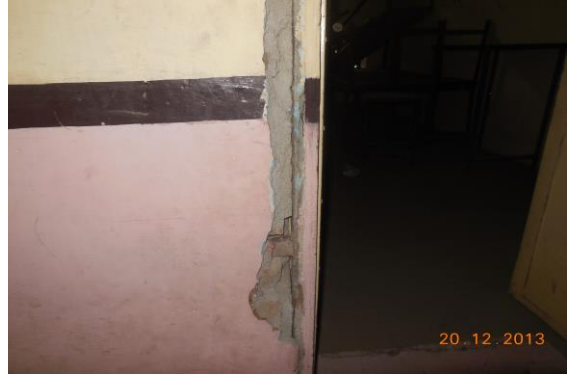
Photo 133
Damaged Portion on Wall No. 3 of Passage No.1 of First Floor

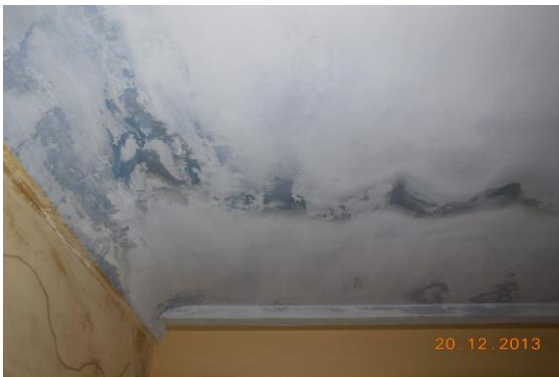
Photo 134
Dampness/Seepage on Roof of Room No. 4 of First Floor

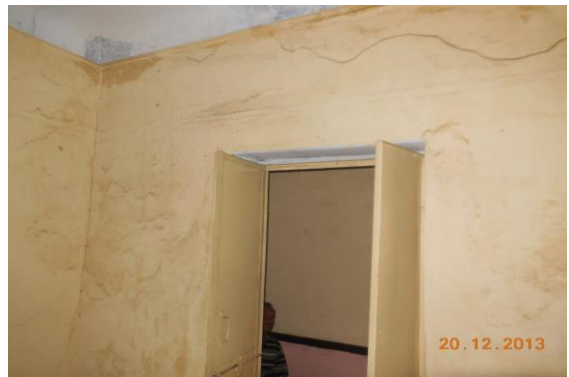
Photo 135
Dampness/Seepage on Wall No. 3 of Room No. 4 of First Floor

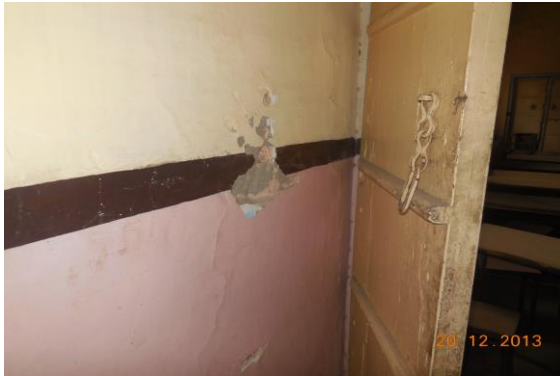
Photo 136
Damaged Portion on Wall No. 4 of Passage of First Floor

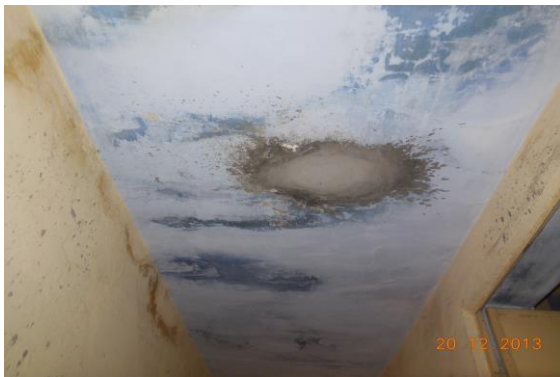
Photo 138
Damaged Portion on Roof of Passage No.2 of First Floor

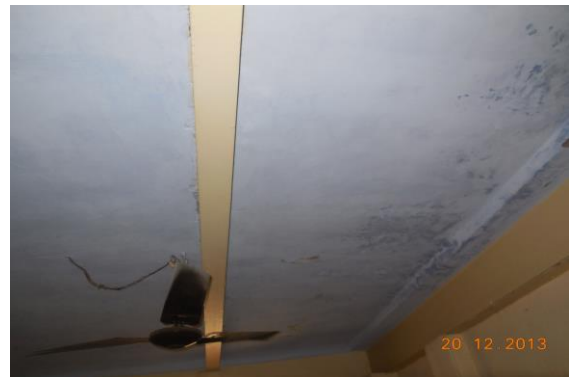
Photo 139
Dampness/Seepage on Roof of Room No. 5 of First Floor

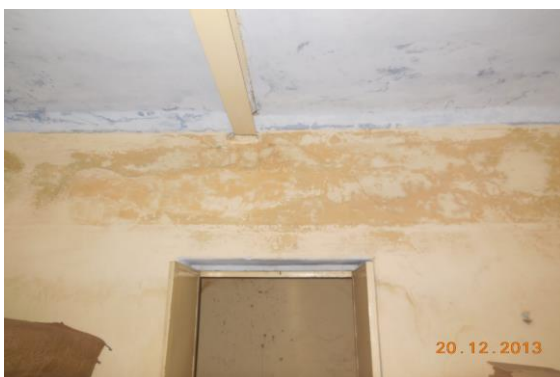
Photo 140
Dampness/Seepage on Wall No. 3 of Room No. 5 of First Floor

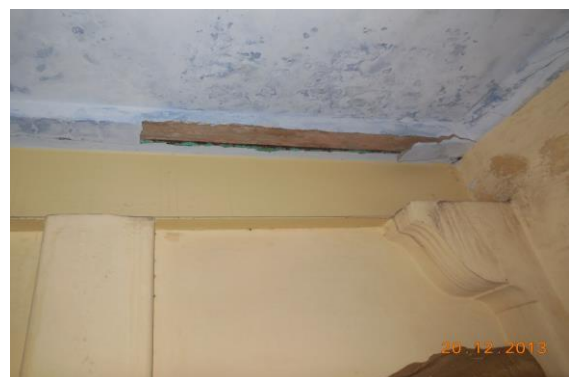
Photo 141
Damaged Portion on Roof of Room No. 5 of First Floor

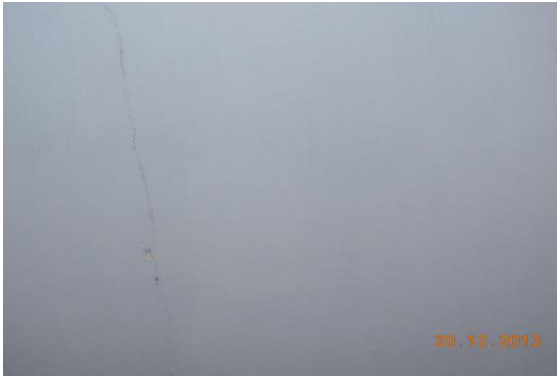
Photo 142
Peeling of Plaster on Roof of Room No. 6 of First Floor

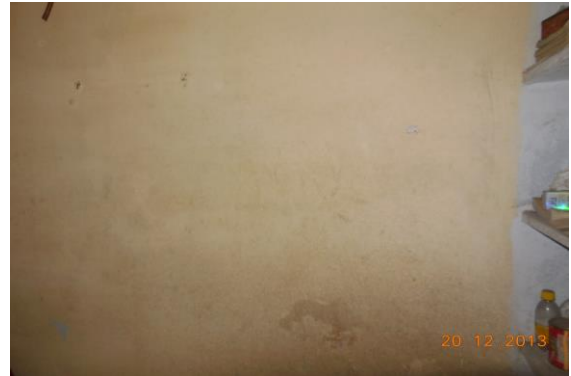
Photo 143
Dampness/Seepage on Wall No. 2 of Room No. 7 of First Floor
