Pre Building Condition Survey Report

Name and Address of Structure :	Choti Chopar to Badi Chopar (Down Line)
---------------------------------	---

Name of the Project	Contract JMRC-UG1B “Design and Construction of Tunnel between Chandpole and Badi Chouper and reverse line by Shield TBM, Underground Metro Stations at Choti Chouper and Badi Chouper by Cut and Cover Methods on East West Corridor of Jaipur Metro Rail Corporation Limited .”	
Owner :

Pre Building Condition Survey Report Choti Chopar to Badi Chopar (Down Line)

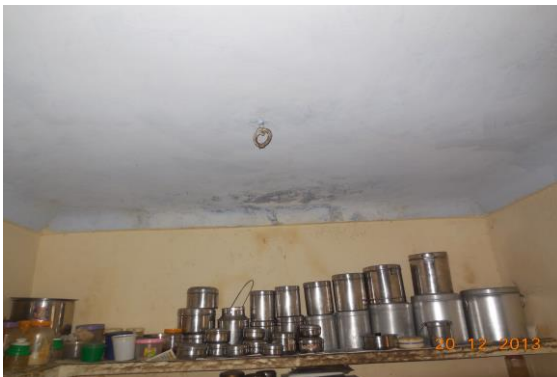
Photo 144
Dampness/Seepage on Roof of Kitchen of First Floor

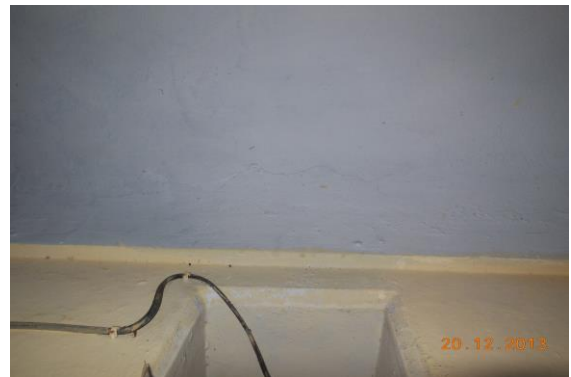
Photo 145
Peeling of Plaster on Roof of Kitchen of First Floor

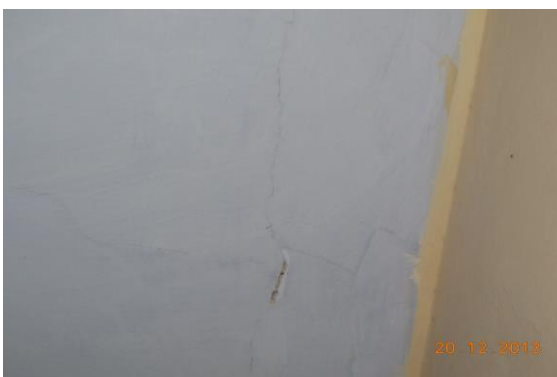
Photo 146
Peeling of Plaster on Roof of Room No. 8 of First Floor

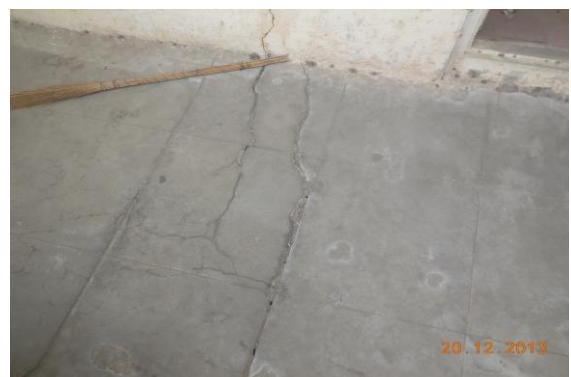
Photo 147
Damaged Portion on Floor of Open Sky of Second Floor

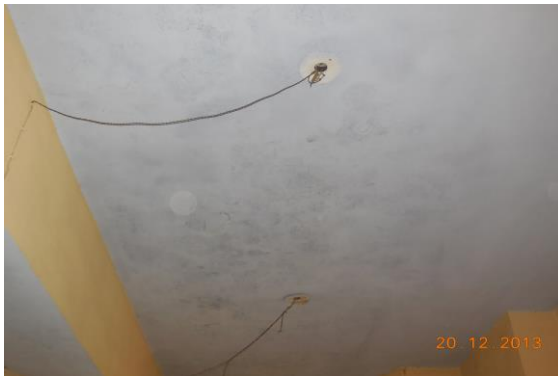
Photo 148
Dampness/Seepage on Roof of Hall No. 2 of Second Floor

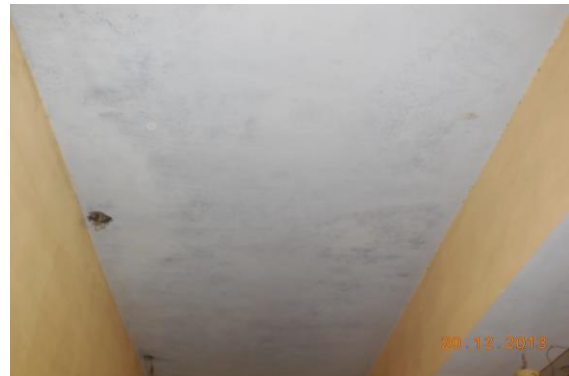
Photo 149
Dampness/Seepage on Roof of Hall No. 2 of Second Floor

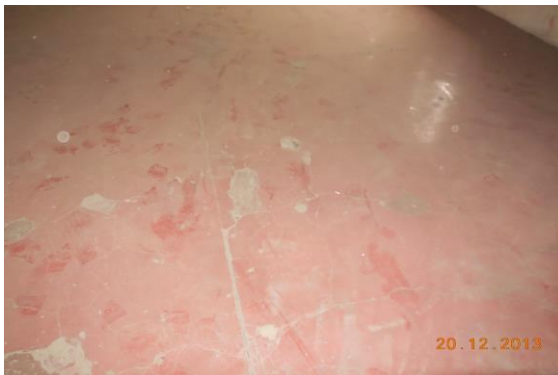
Photo 150
Peeling of Plaster on Floor of Hall No. 3 of Second Floor

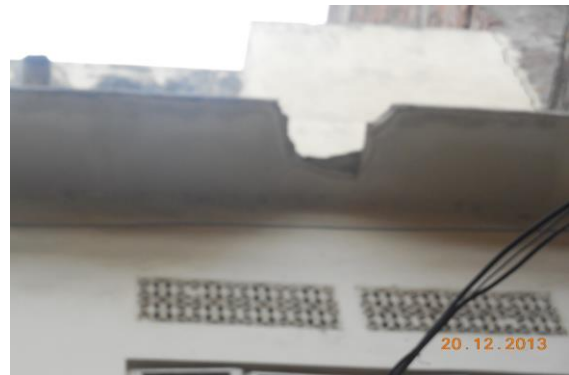
Photo 151
Damaged Portion on Outside Front Wall no.3 of Building of First Floor

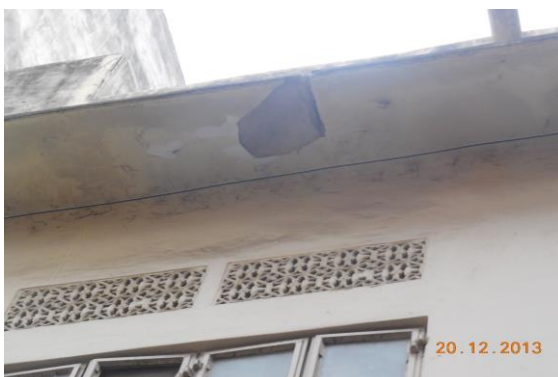
Photo 152
Damaged Portion on Outside Front Wall no.3 of Building of Second Floor

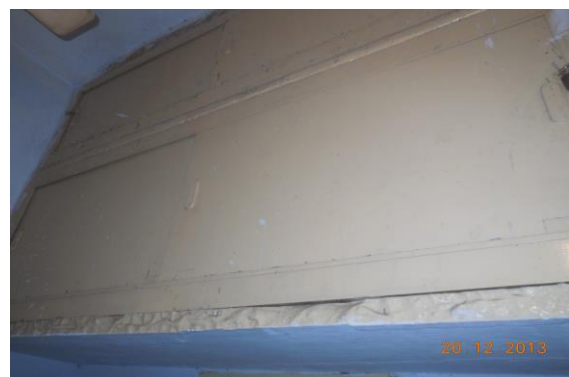
Photo 153
Wall No. 2 of Kitchen of Ground Floor Upper Portion Covered With almirah

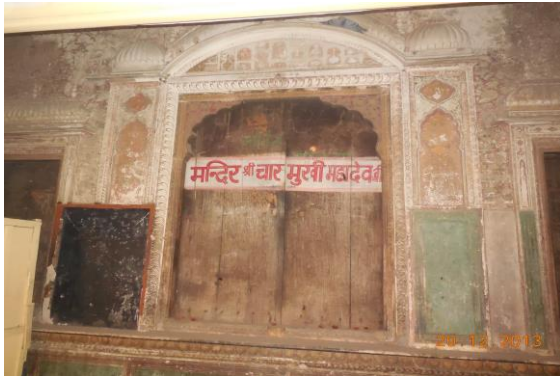
Photo 154
Temple of Ground Floor Locked

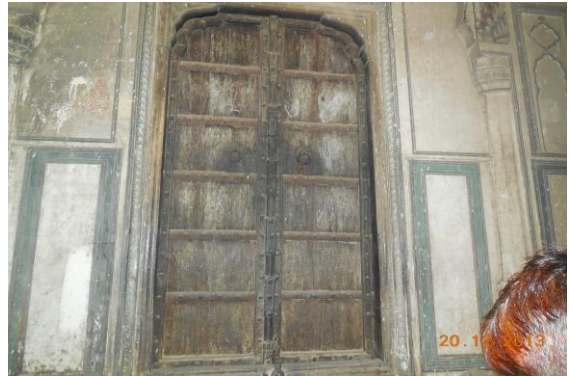
Photo 155
Temple of Ground Floor Locked

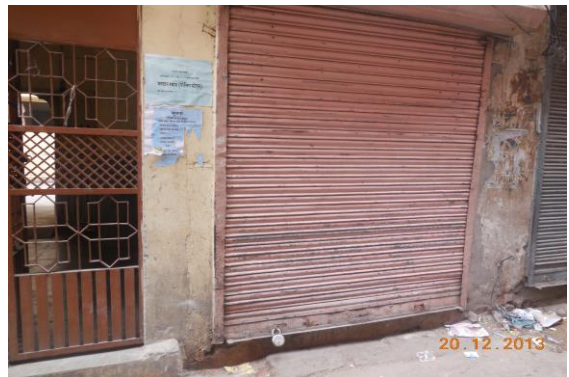
Photo 157
Shop No.2 of Ground Floor Locked

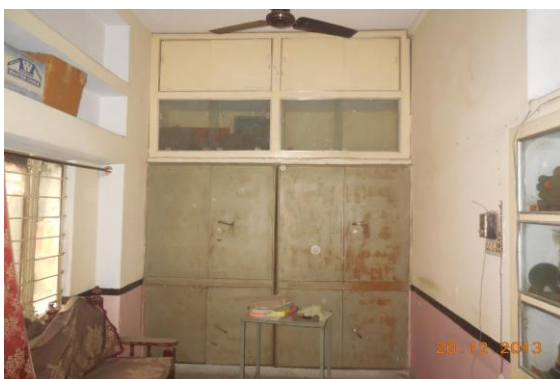
Photo 158
Wall No. 2 of Room No. 1 of First Floor Covered with almira

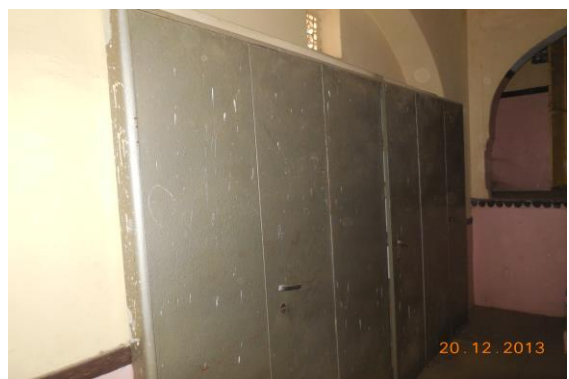
Photo 159
Wall No. 4 of Hall No. 3 of Part A of Hall. First Floor Half Wall cover with Almira

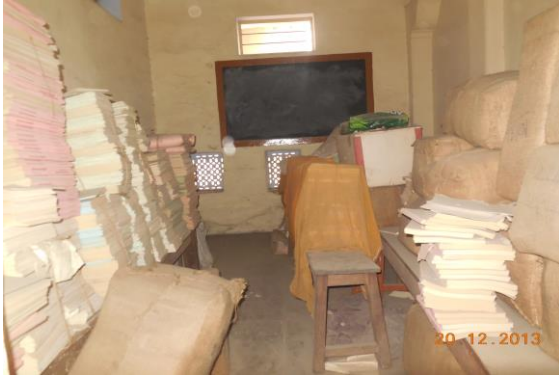
Photo 160
Wall No. 1 & 2 of First Floor

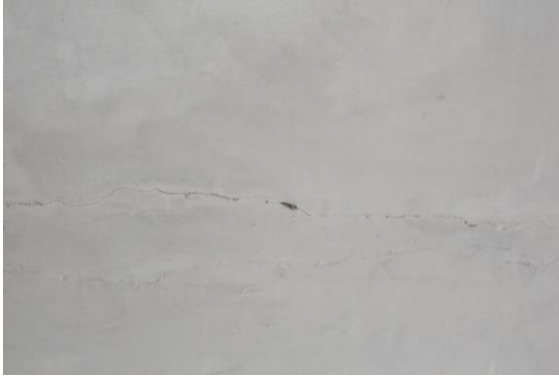
Photo 61

Horizontal Crack on Roof of Varanda of Shop No.347, Ground Floor, Approx. Width = 0.4mm, Approx. Length = 3m. Distance from Backside Right side External Column, Height from Floor = 3m.

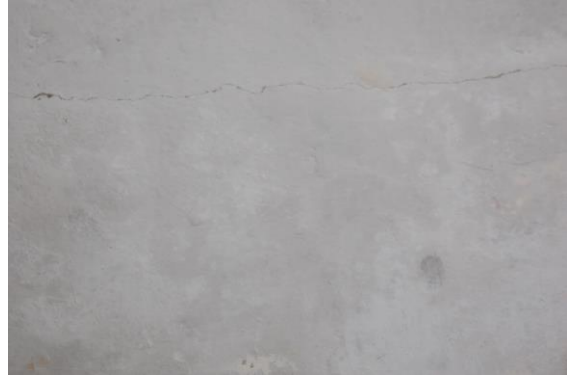
Photo 62

Horizontal Crack on Roof of Varanda of Shop No.346, G. Floor, Approx. Width = 0.3mm, Length = 3m. Distance Backside Right side External Column = 1.5m, Height Floor = 3m.

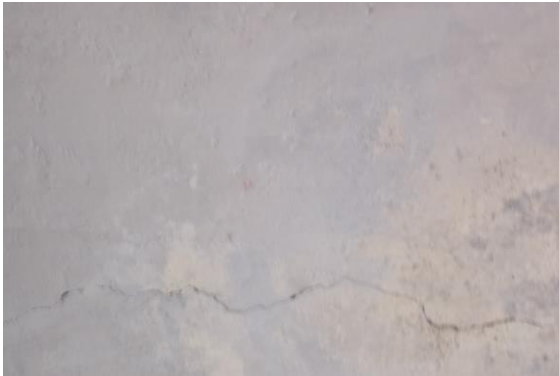
Photo 63

Horizontal Crack on Roof of Varanda of Shop No.345, Ground Floor, Approx. Width = 0.6mm, Approx. Length = 3m. Distance from Backside External Column = 1.3m, Height from Floor = 3m.

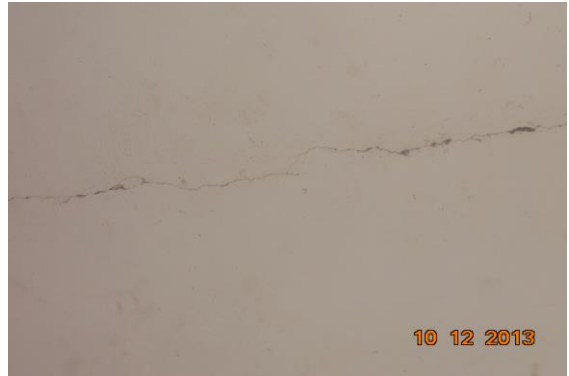
Photo 64

Horizontal Crack on Roof of Shop No.29, Ground Floor, Approx. Width = 0.35mm, Approx. Length = 3m. Distance from Wall No.4 = 3.3m, Height from Floor = 4m.

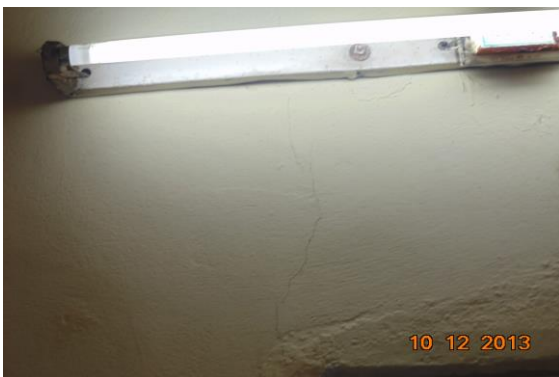
Photo 65

Vertical Crack on Wall No. 4 of Part-I, Shop No.31, Ground Floor, Approx. Width = 0.25mm, Approx. Length = 0.35m. Distance from Wall No.1 = 1.2m, Height from Floor = 2m.

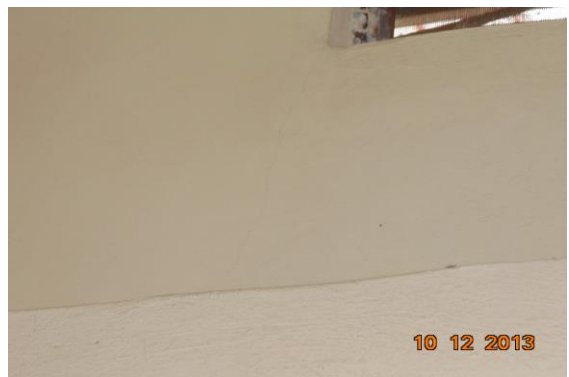
Photo 66

Inclined Crack on Wall No. 3 of Part-I, Shop No.31, Ground Floor, Approx. Width = 0.2mm, Approx. Length = 0.6m. Distance from Wall No.2 = 0.85m, Height from Floor = 2.5m.

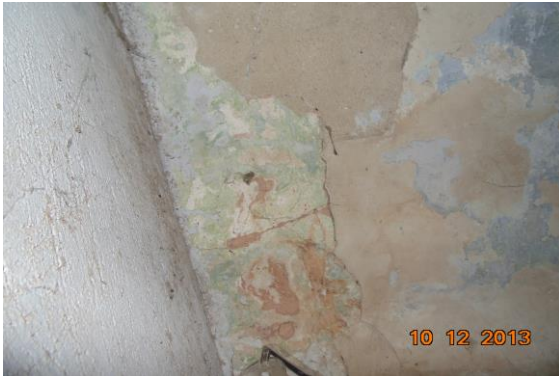
Photo 67

Vertical Crack on Wall No. 4 of Lobby, First Floor, Approx. Width = 0.8mm, Approx. Length = 1.2m. Distance from Wall No. 1 = 0.25m, Height from Floor = 0.8m.

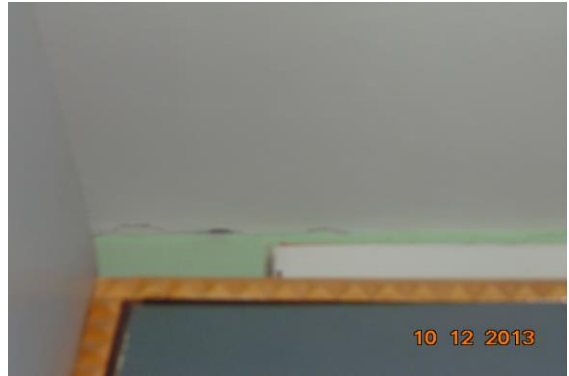
Photo 68

Horizontal Crack on Wall No. 4 of Shop No. 2, First Floor, Approx. Width = 0.6mm, Approx. Length = 4m. Distance from Wall No. 4 = 0m, Height from Floor = 3.5m.

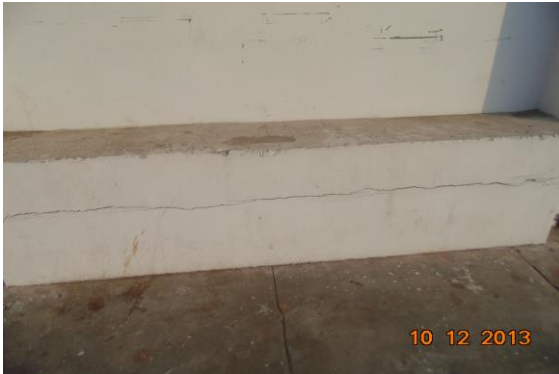
Photo 69

Horizontal Crack on Outer Wall of Shop No. 201 to 203, Second Floor, Approx. Width = 4mm, Approx. Length = 3m. Distance from Shop No. 202 & 203 = 0m, Height from Floor = 0.5m.

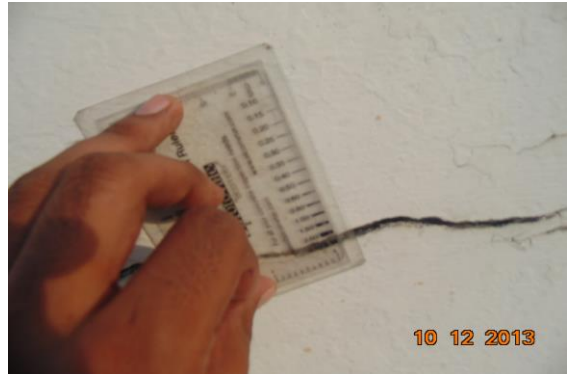
Photo 69A

Horizontal Crack on Outer Wall of Shop No. 201 to 203, Second Floor, Approx. Width = 4mm, Approx. Length = 3m. Distance from Shop No. 202 & 203 = 0m, Height from Floor = 0.5m.

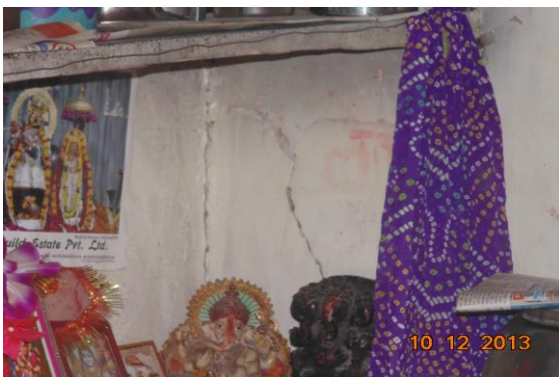
Photo 70

Inclined Crack on Wall No. 4 of Kitchen, Second Floor, Approx. Width = 2mm, Approx. Length = 0.4m. Distance from Wall No. 1 = 0m, Height from Floor = 1m.

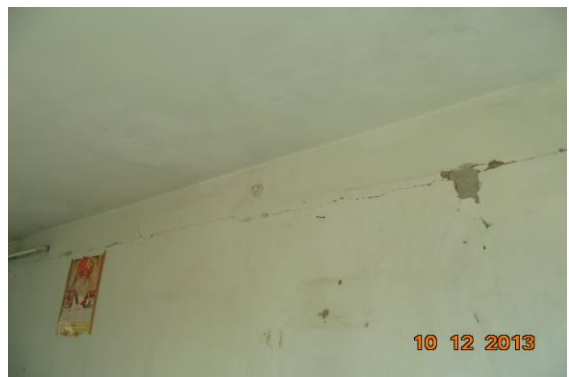
Photo 71

Horizontal Crack on Wall No. 2 of Shop No. 304, Third Floor, Approx. Width = 0.35mm, Approx. Length = 6m. Distance from Wall no. 4 = 0m, Height from Floor = 2.3m.

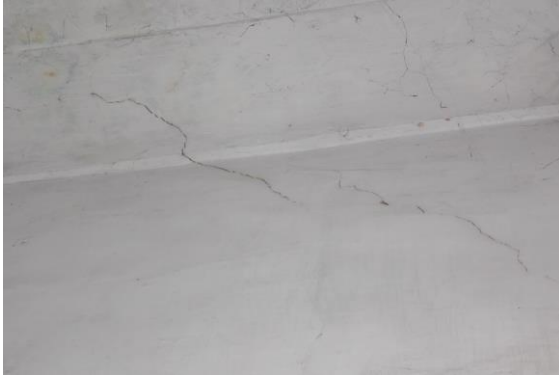
Photo 72

Inclined Crack on Wall No. 1 of Room No. 1, Temple First Floor, Approx. Width = 2.5mm, Approx. Length = 3m. Distance from Wall No.4 = 0.3m, Height from Floor = 3.5m.

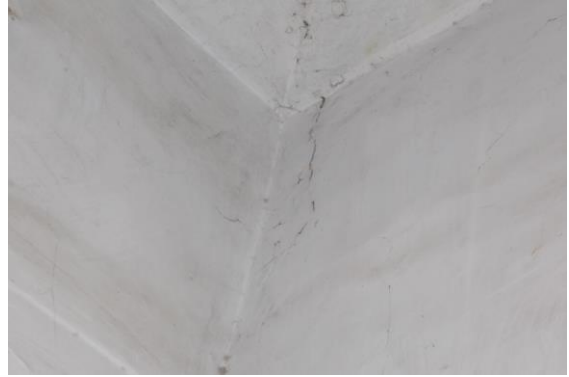
Photo 73

Inclined Crack on Wall No. 1 of Room No. 1, Temple First Floor, Approx. Width = 2.5mm, Approx. Length = 3.5m. Distance from Wall No.3 = 0m, Height from Floor = 3m.

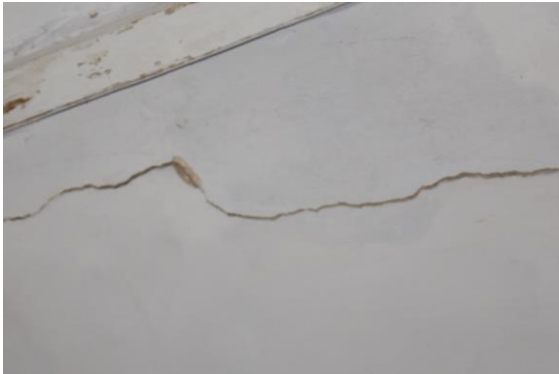
Photo 74

Horizontal Crack on Roof of Room No. 2, Temple First Floor, Approx. Width = 10mm, Approx. Length = 3.5m. Distance from Wall No.1 = 1.5m, Height from Floor = 4.5m.

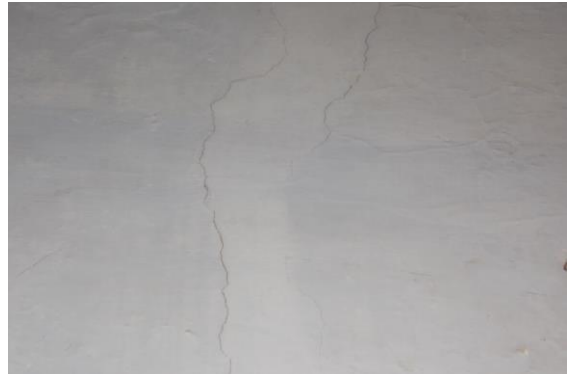
Photo 75

Vertical Crack on of Lobby No.1, Shri Krishna Chandra Ji Temple, First Floor, Approx. Width = 0.2mm, Approx. Length = 3m. Distance from Wall No.1 = 2m, Height from Floor = 1.5m.

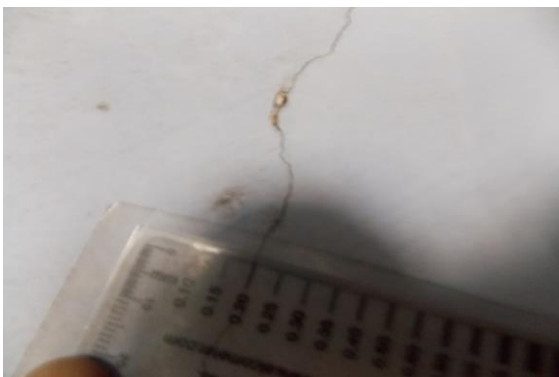
Photo 75A

Vertical Crack on of Lobby No.1, Shri Krishna Chandra Ji Temple, First Floor, Approx. Width = 0.2mm, Approx. Length = 3m. Distance from Wall No.1 = 2m, Height from Floor = 1.5m.

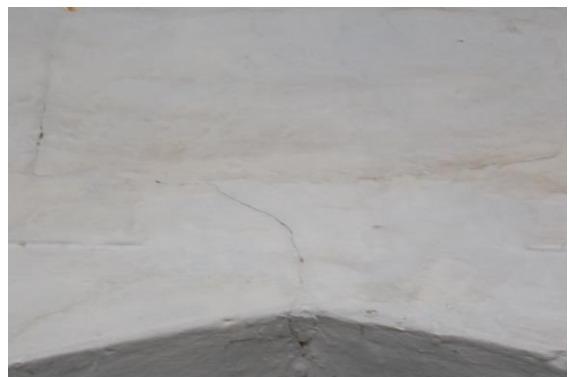
Photo 76

Horizontal Crack on Roof of Lobby No.1, Shri Krishna Chandra Ji Temple, First Floor, Approx. Width = 0.4mm, Approx. Length = 2.5m. Distance from Wall No.1 = 0m, Height from Floor = 4m.

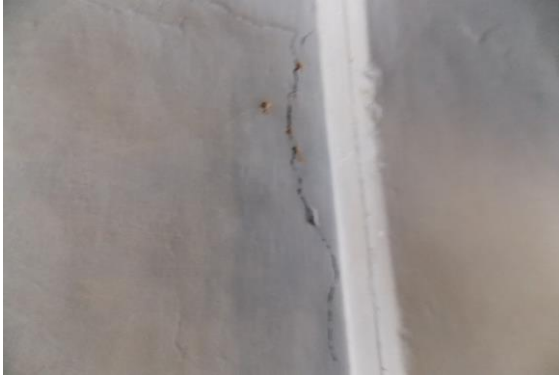
Photo 77

Vertical Crack on Wall No. 1 of Lobby No.1, Shri Krishna Chandra Ji Temple, First Floor, Approx. Width = 3mm, Approx. Length = 2m. Distance from Wall no.4 = 2m, Height from Floor = 0m.

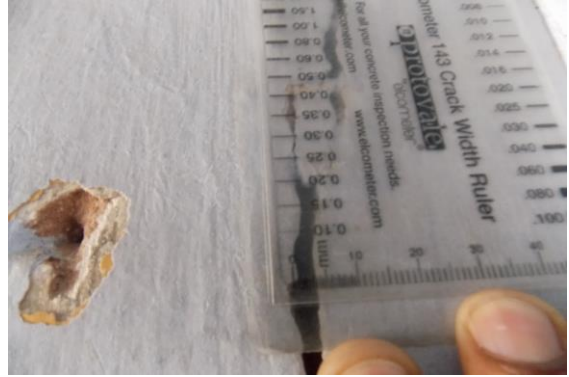
Photo 77A

Vertical Crack on Wall No. 1 of Lobby No.1, Shri Krishna Chandra Ji Temple, First Floor, Approx. Width = 3mm, Approx. Length = 2m. Distance from Wall no.4 = 2m, Height from Floor = 0m.

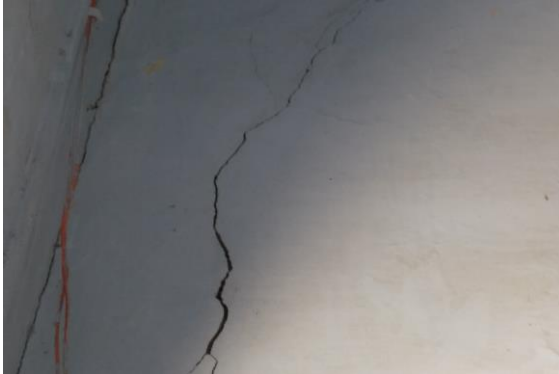
Photo 78

Inclined Crack on Wall No. 1 & Roof of Lobby No.1, Shri Krishna Chandra Ji Temple, First Floor, Approx. Width = 2mm, Approx. Length = 2.5m. Distance from Wall No.3 = 0m, Height Floor = 2m.

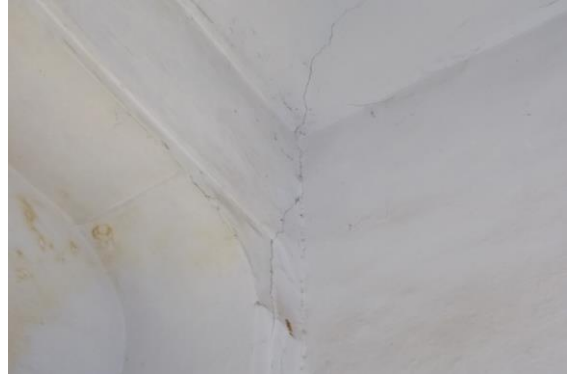
Photo 79

Vertical Crack on Wall No. 2 & 4 of Room No. 3, Shri Krishna Chandra Ji Temple, First Floor, Approx. Width = 1mm, Approx. Length = 2.9m. Distance Wall No.2 & 4 = 0m, Height Floor = 1.6m.

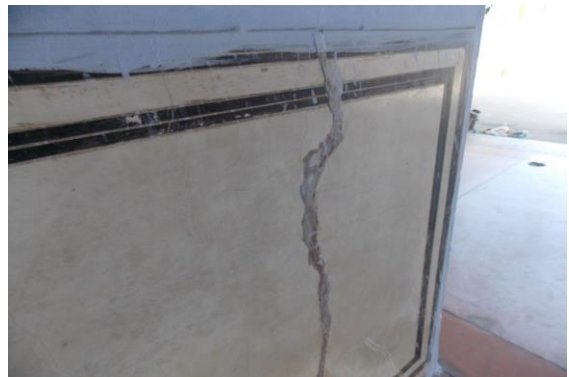
Photo 81

Vertical Crack on Wall No. 1 of Varanda No.3, Shri Krishna Chandra Ji Temple, First Floor, Approx. Width = 10mm, Approx. Length = 2m.

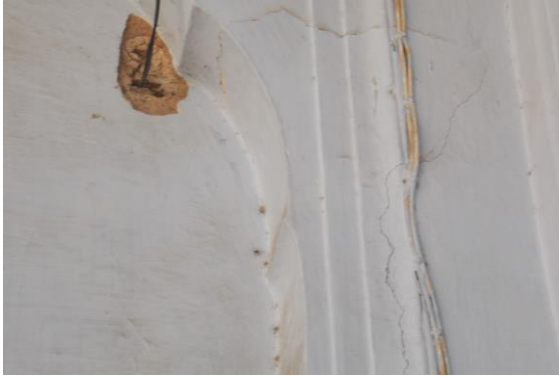
Photo 82

Inclined Crack on Wall No. 1 of Open to Sky Area No.3, Shri Krishna Chandra Ji Temple, F F, Approx. Width = 0.2mm, Approx. Length = 2m. Distance from Wall no.4 = 0m, Height Floor = 1.3m.

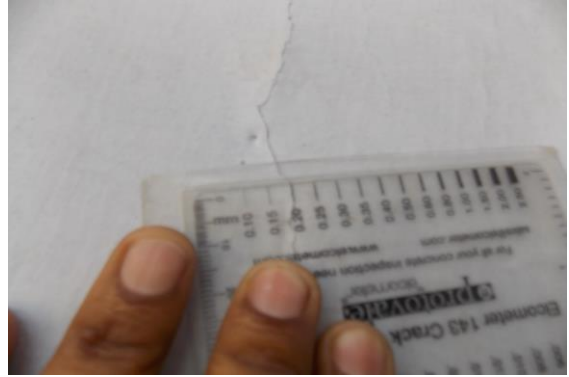
Photo 83

Inclined Crack on Wall No. 1 of Open to Sky Area No.3, Shri Krishna Chandra Ji Temple, FF, Approx. Width = 0.2mm, Approx. Length = 2m. Distance from Wall no.4 = 0m, Height Floor = 1.3m.

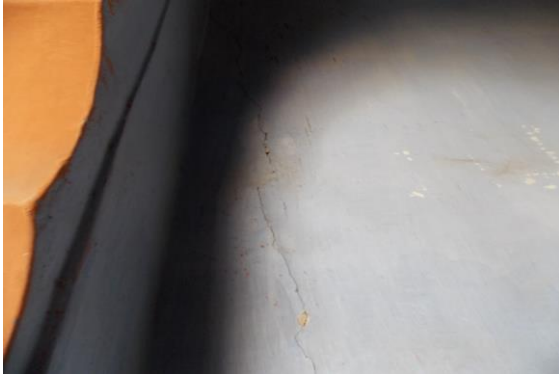
Photo 84

Inclined Crack on Wall No. 4 of Lobby No.4, Shri Krishna Chandra Ji Temple, First Floor, Approx. Width = 0.3mm, Approx. Length = 2.5m. Distance from Wall No.2 = 2m, Height from Floor = 1m.

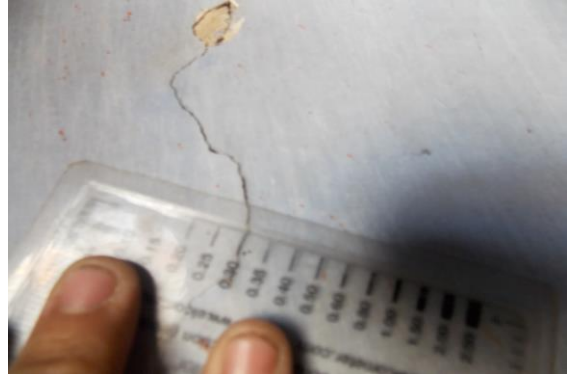
Photo 84A

Inclined Crack on Wall No. 4 of Lobby No.4, Shri Krishna Chandra Ji Temple, First Floor, Approx. Width = 0.3mm, Approx. Length = 2.5m. Distance from Wall No.2 = 2m, Height from Floor = 1m.

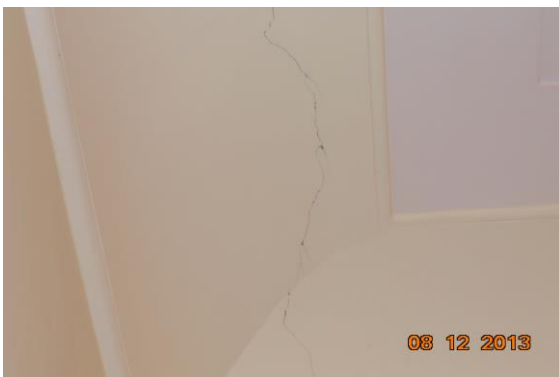
Photo 85

Inclined Crack on Wall No. 4 & Roof of Room No. 7, Shri Krishna Chandra Ji Temple First Floor, Approx. Width = 0.5mm, Approx. Length = 2.5m. Distance from Wall No.1 = 3.7m, Height Floor = 3.3m.

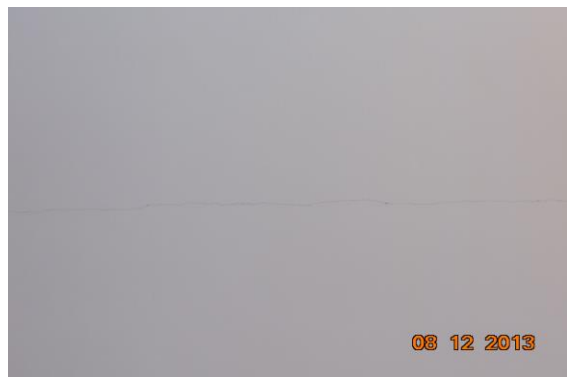
Photo 86

Horizontal Crack on Roof of Room No. 7, Shri Krishna Chandra Ji Temple First Floor, Approx. Width = 0.35mm, Approx. Length = 3m. Distance from Wall No.2 = 4.5m, Height from Floor = 4m.

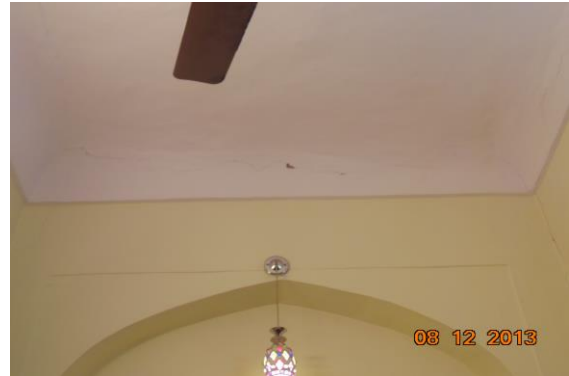
Photo 88

Inclined Crack on Wall No. 1, 3 & Roof of Room No. 7, Shri Krishna Chandra Ji Temple First Floor, Approx. Width = 0.35mm, Approx. Length = 6m. Distance Wall No 1 & 4 = 0m, Height Floor = 2.5m.

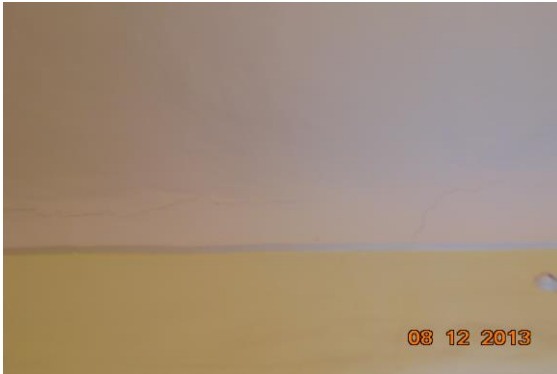
Photo 89

Inclined Crack on Wall No. 1 of Room No. 7, Shri Krishna Chandra Ji Temple First Floor, Approx. Width = 0.4mm, Approx. Length = 2.7m. Distance from Wall No.3 = 2m, Height from Floor = 3m.

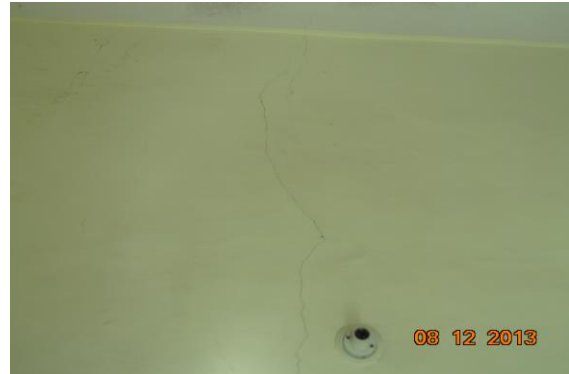
Photo 90

Inclined Crack on Wall No. 4 of Room No. 10, Shri Krishna Chandra Ji Temple First Floor, Approx. Width = 0.2mm, Approx. Length = 5m. Distance from Wall No.1 = 0.3m, Height from Floor = 0m.

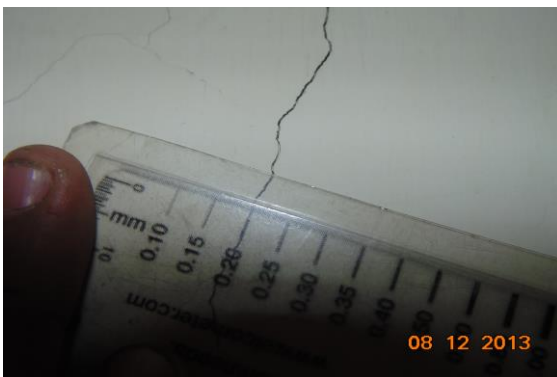
Photo 90A

Inclined Crack on Wall No. 4 of Room No. 10, Shri Krishna Chandra Ji Temple First Floor, Approx. Width = 0.2mm, Approx. Length = 5m. Distance from Wall No.1 = 0.3m, Height from Floor = 0m.

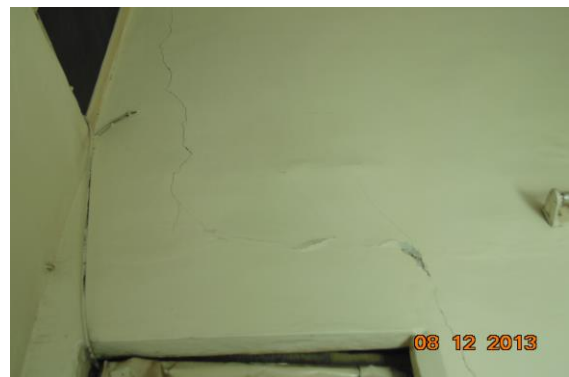
Photo 91

Inclined Crack on Wall No. 4 of Room No. 11, Shri Krishna Chandra Ji Temple First Floor, Approx. Width = 0.2mm, Approx. Length = 4.5m. Distance from Wall No.1 = 1.1m, Height from Floor = 0.4m.

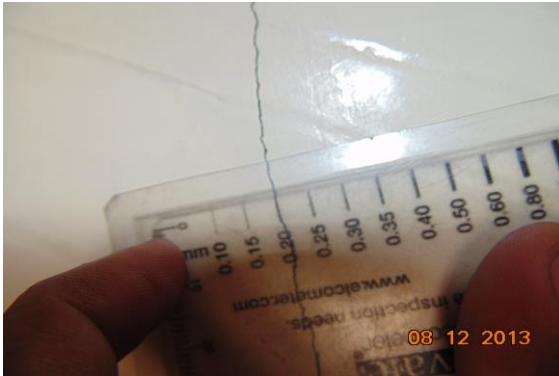
Photo 91A

Inclined Crack on Wall No. 4 of Room No. 11, Shri Krishna Chandra Ji Temple First Floor, Approx. Width = 0.2mm, Approx. Length = 4.5m. Distance from Wall No.1 = 1.1m, Height from Floor = 0.4m.

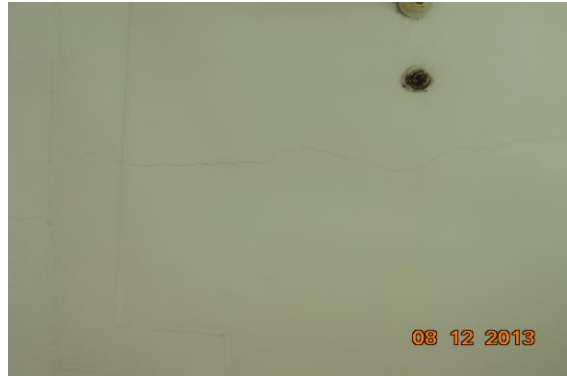
Photo 92

Horizontal Crack on Roof of Room No. 11, Shri Krishna Chandra Ji Temple First Floor, Approx. Width = 0.5mm, Approx. Length = 3m. Distance from Wall No.2 = 1.3m, Height from Floor = 4.5m.

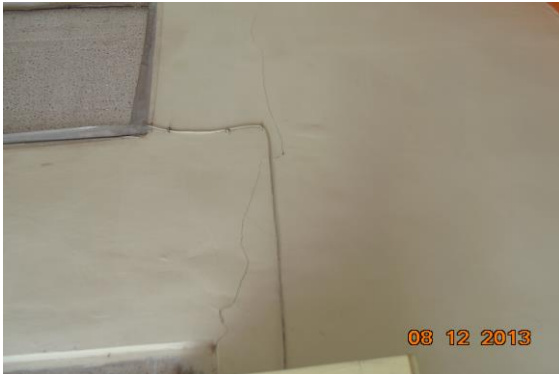
Photo 93

Inclined Crack on Wall No. 3 of Room No. 11, Shri Krishna Chandra Ji Temple First Floor, Approx. Width = 0.25mm, Approx. Length = 2.5m. Distance from Wall No.1 = 1m, Height from Floor = 1.1m.

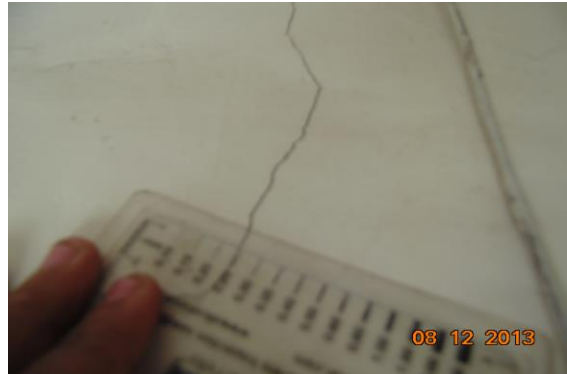
Photo 93A

Inclined Crack on Wall No. 3 of Room No. 11, Shri Krishna Chandra Ji Temple First Floor, Approx. Width = 0.25mm, Approx. Length = 2.5m. Distance from Wall No.1 = 1m, Height from Floor = 1.1m.

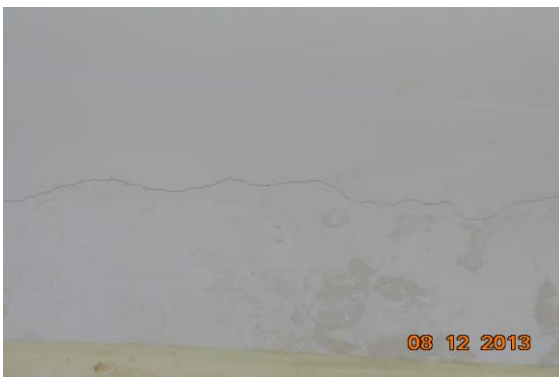
Photo 94

Horizontal Crack on Roof of Room No. 12, Shri Krishna Chandra Ji Temple First Floor, Approx. Width = 0.35mm, Approx. Length = 2.5m. Distance from Wall No.1 = 0m, Height from Floor = 4m.

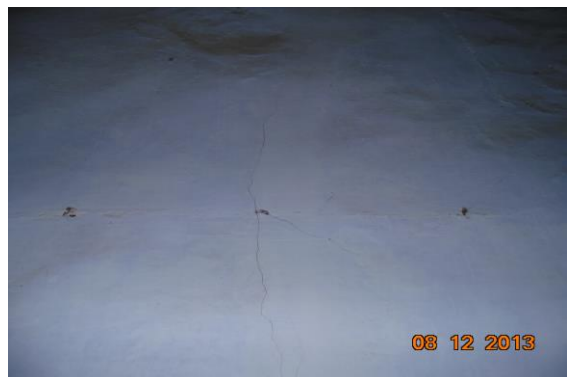
Photo 95

Inclined Crack on Wall No. 1 of Lobby No.3, Shri Krishna Chandra Ji Temple, First Floor, Approx. Width = 0.25mm, Approx. Length = 1.5m. Distance from Wall No.3 = 7m, Height from Floor = 1.1m.

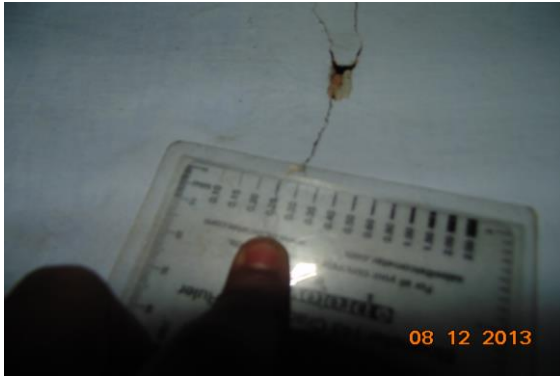
Photo 95A

Inclined Crack on Wall No. 1 of Lobby No.3, Shri Krishna Chandra Ji Temple, First Floor, Approx. Width = 0.25mm, Approx. Length = 1.5m. Distance from Wall No.3 = 7m, Height from Floor = 1.1m.

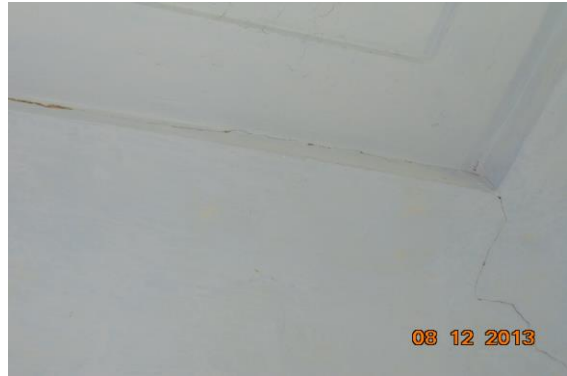
Photo 96

Inclined Crack on Wall No. 2,3& Roof of Shri Krishna Chandra Ji Temple, First Floor, Approx. Width = 0.5mm, Approx. Length = 4m. Distance from Wall no.3 = 0m, Height from Floor = 2.5m.

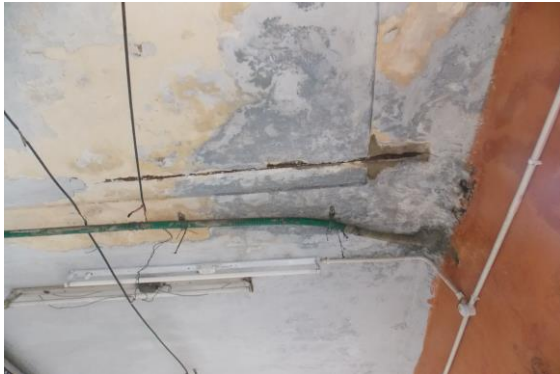
Photo 97

Exposed Reinforcement on Roof of Varanda of Shop no.348 & 349 of Ground Floor

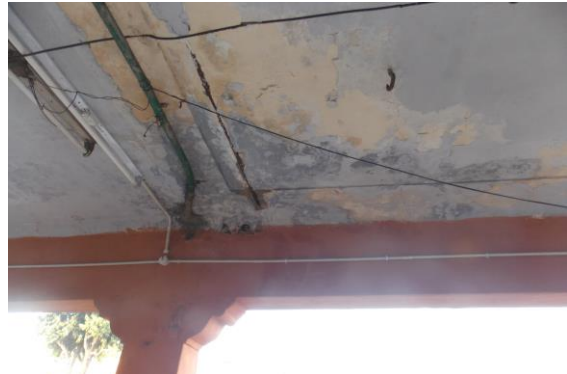
Photo 98

Dampness/Seepage on Roof of Varanda of Shop no.348 & 349 of Ground Floor

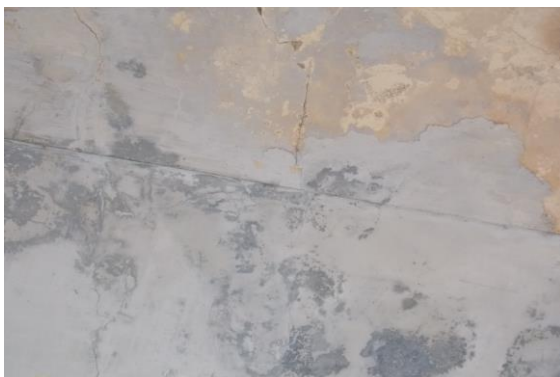
Photo 99

Peeling of Plaster on Roof of Varanda of Shop no.348 & 349 of Ground Floor

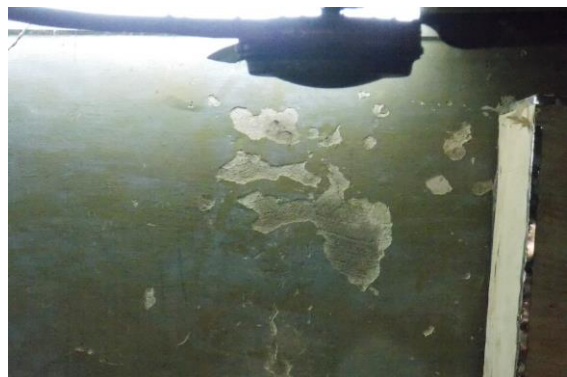
Photo 100

Peeling of Plaster on Wall No. 4 of Shop no.347 of Lower Ground Floor

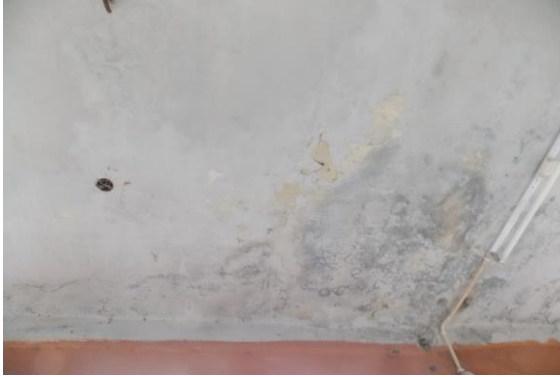
Photo 101

Dampness/Seepage on Roof of Varanda of Shop No.347 of Ground Floor

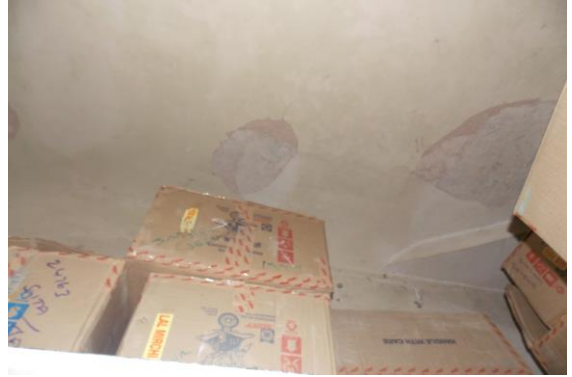
Photo 102

Peeling of Plaster on Roof of Part B Shop No.346 of Ground Floor

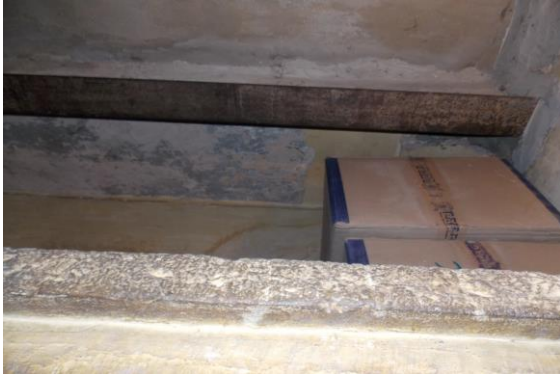
Photo 103

Peeling of Plaster on Roof of Part C Shop No.346 of Ground Floor

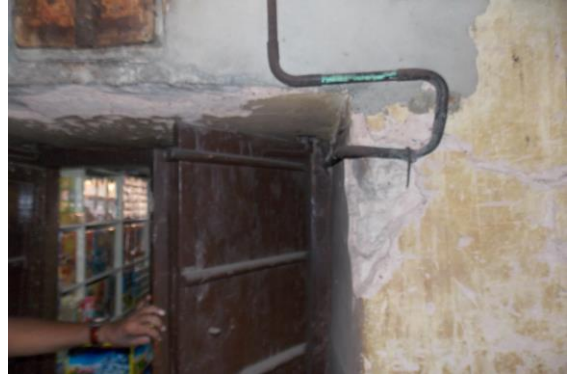
Photo 104

Damaged Portion on Wall No. 3 of Part C Shop No.346 of Ground Floor

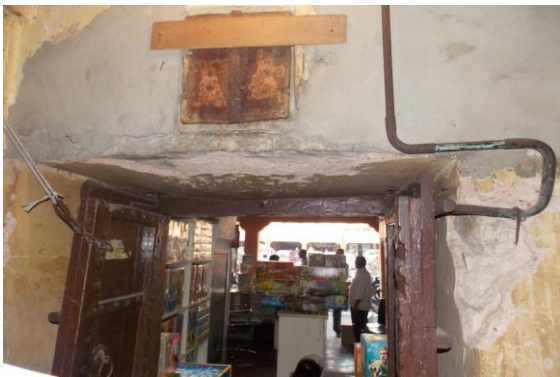
Photo 105

Damaged Portion on Wall No. 3 of Part C Shop No.346 of Ground Floor

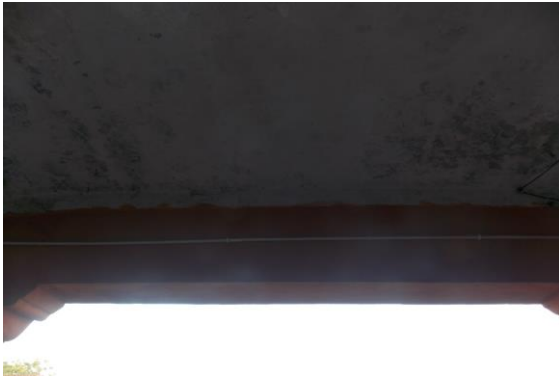
Photo 107

Dampness/Seepage on Roof of Varanda of Shop No.346 of Ground Floor

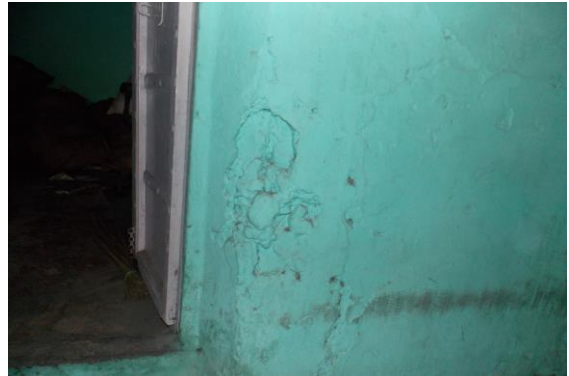
Photo 108

Peeling of Plaster on Wall No. 4 of Part B of Shop no.345 of Ground Floor

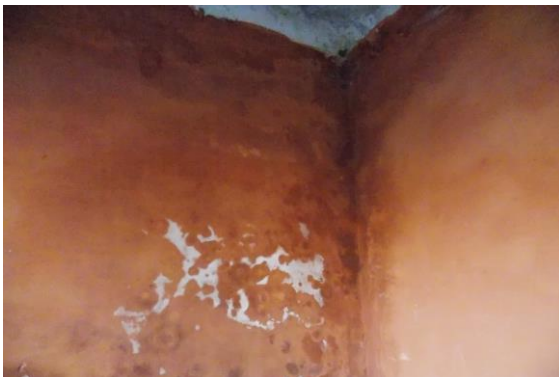
Photo 109

Dampness/Seepage on Wall No. 1 & 4 of Varanda of Shop No.345 of Ground Floor

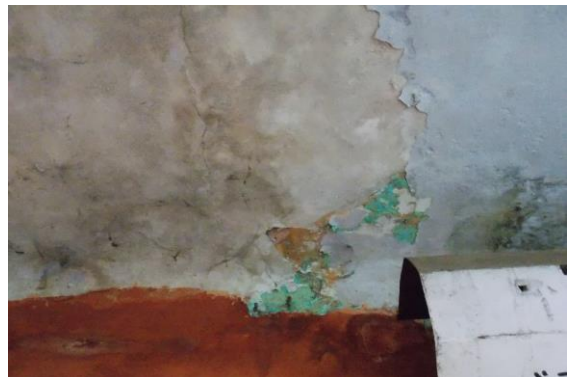
Photo 110

Peeling of Plaster on Roof of Varanda of Shop No.345 of Ground Floor

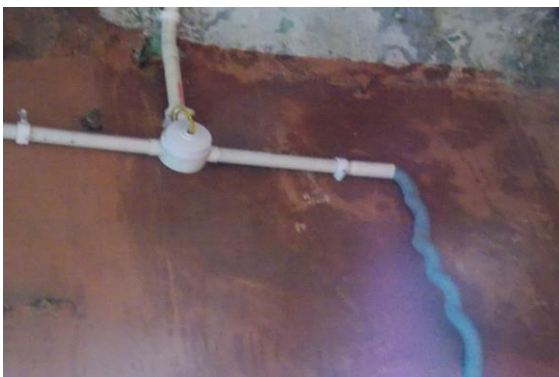
Photo 111

Dampness/Seepage on Backside Left side External Column of Varanda of Shop No.345 of Ground Floor

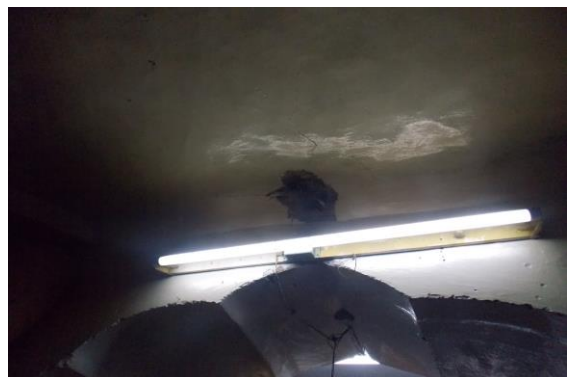
Photo 112

Damaged Portion on Roof of Part B of Shop no.343 of Ground Floor

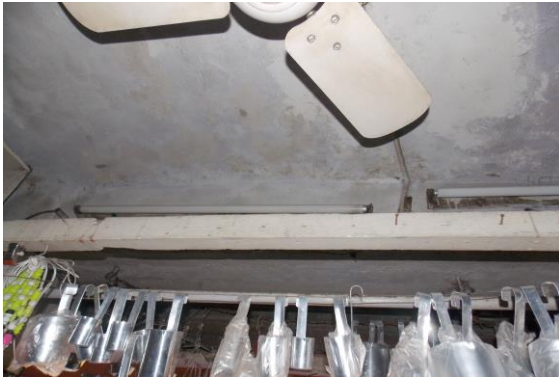
Photo 113

Peeling of Plaster on Roof of Shop no.342 of Ground Floor

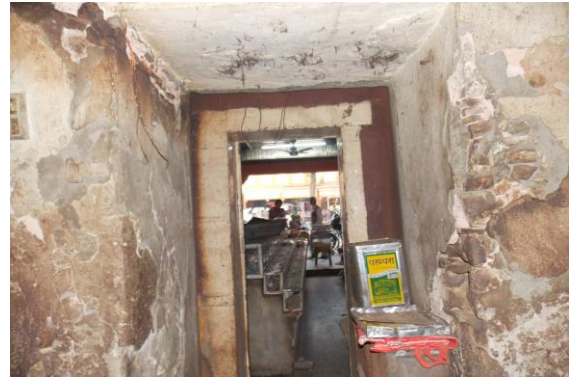
Photo 114

Peeling of Plaster on Roof of Varanda of Shop no.341 of Ground Floor

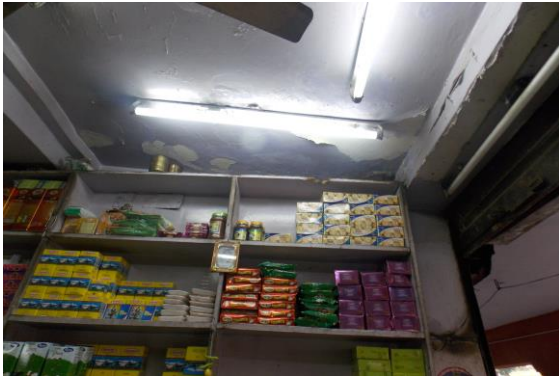
Photo 115

Peeling of Plaster on Roof of Shop No.340 of Ground Floor

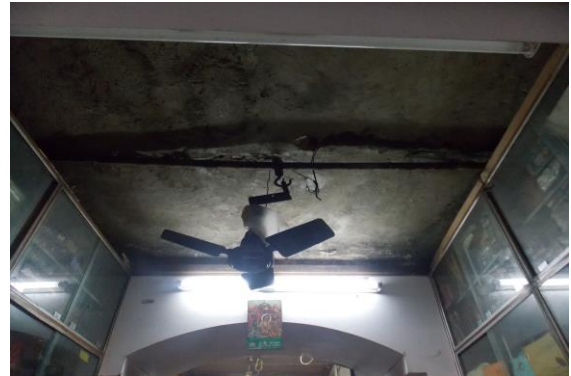
Photo 116

Peeling of Plaster on Roof of Shop No.339 of Ground Floor

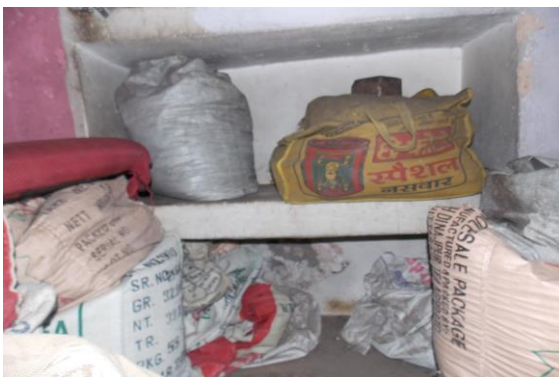
Photo 117

Peeling of Plaster on Wall No. 4 of Part B of Shop no.337 of Ground Floor

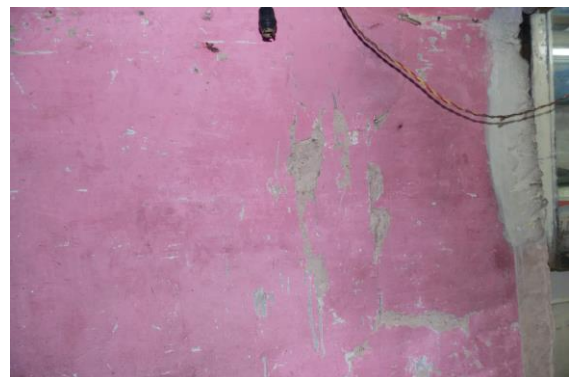
Photo 118

Peeling of Plaster on Wall No. 2 of Part B of Shop no.337 of Ground Floor

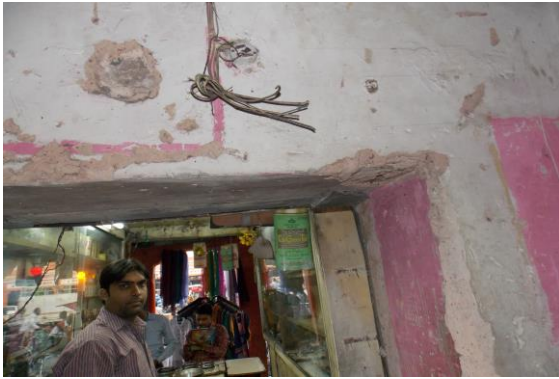
Photo 119

Peeling of Plaster on Wall No. 3 of Part B of Shop no.337 of Ground Floor

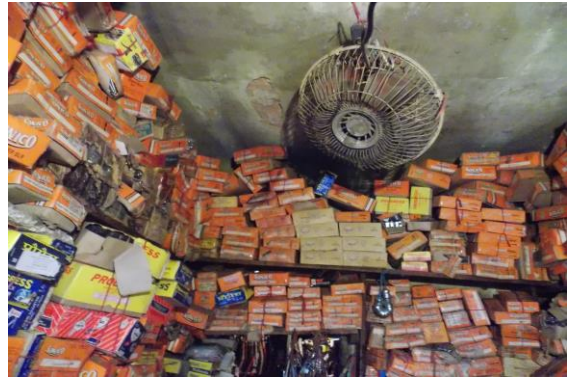
Photo 120

Peeling of Plaster on Roof of Part A Shop No.336 of Ground Floor

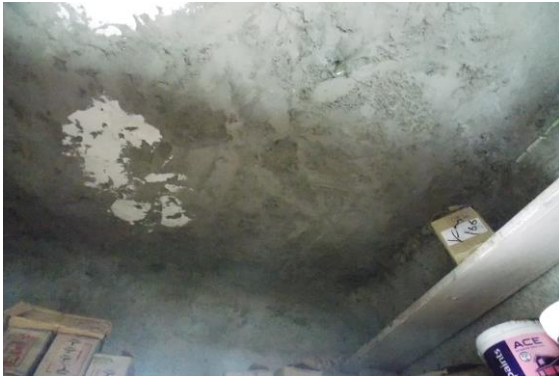
Photo 121

Peeling of Plaster on Roof of Part A Shop No.344 of Ground Floor

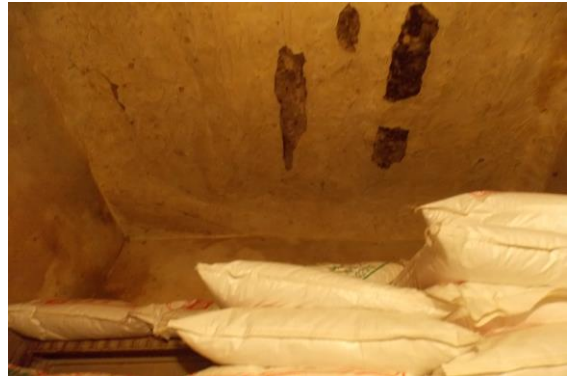
Photo 122

Peeling of Plaster on Roof of Part B Shop No.344 of Ground Floor

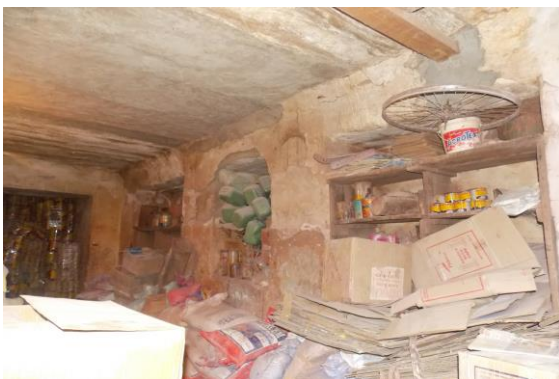
Photo 123

Damaged Portion on Wall No. 4 of Part C Shop No.344 of Ground Floor

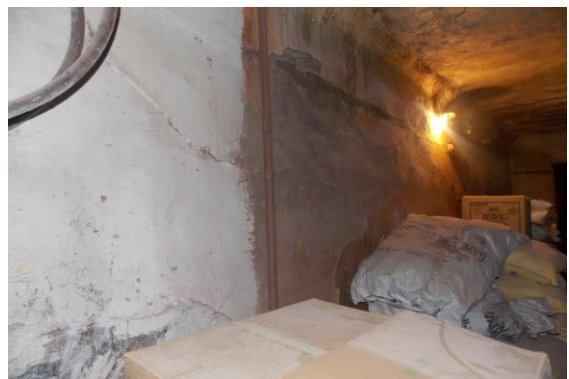
Photo 124

Peeling of Plaster on Wall No. 3 of Part C Shop No.344 of Ground Floor

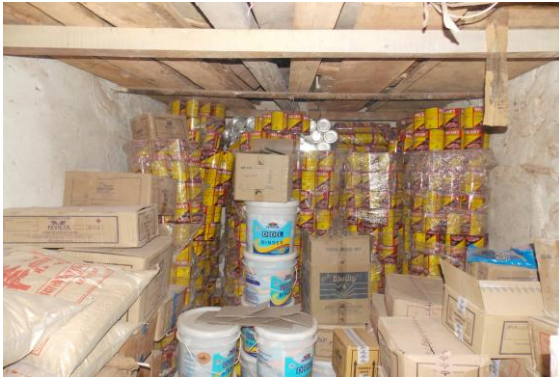
Photo 125

Peeling of Plaster on Roof of Part C Shop No.344 of Ground Floor

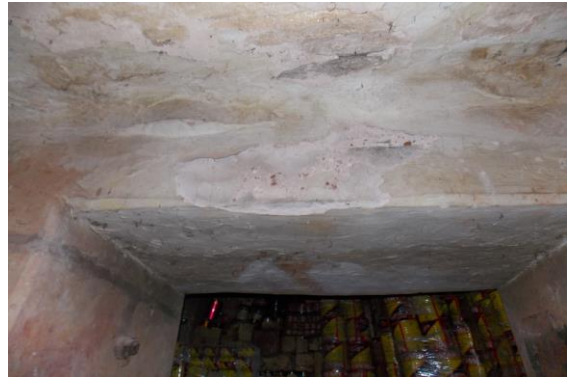
Photo 126

Peeling of Plaster on Wall No. 1 of Part C Shop No.344 of Ground Floor

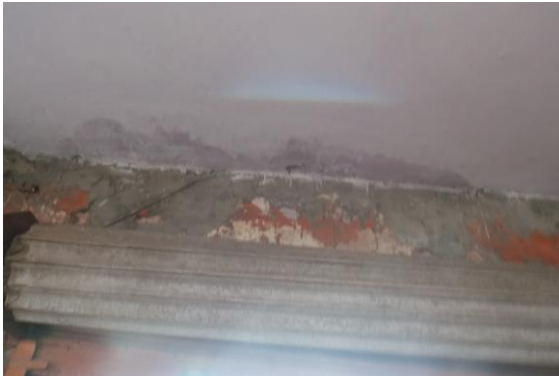
Photo 127

Peeling of Plaster on Wall No. 4 of Varanda of Shop no.344 of Ground Floor

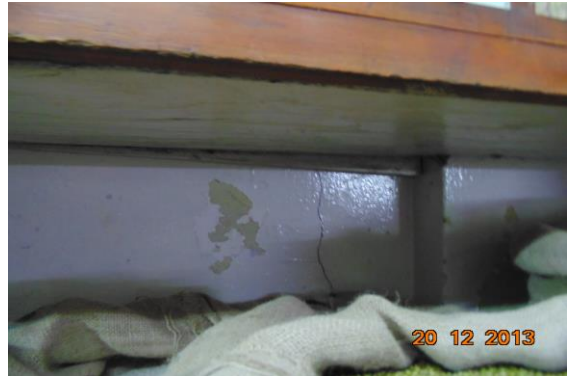
Photo 128

Peeling of Plaster on Wall No. 1 of Shop No.116 of Ground floor

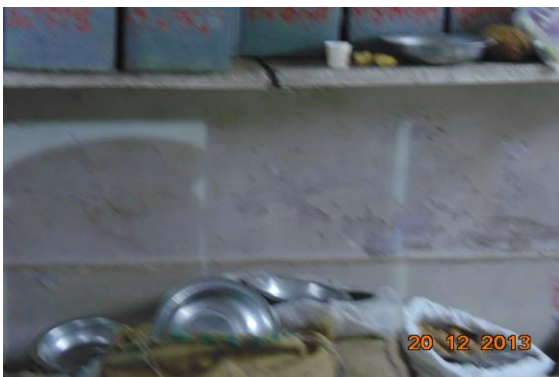
Photo 129

Peeling of Plaster on Wall No. 4 of Shop No.116 of Ground floor

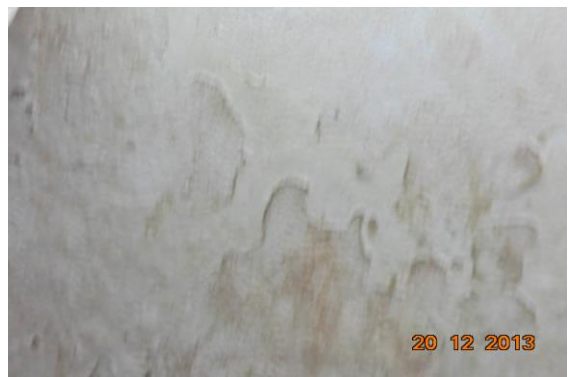
Photo 130

Peeling of Plaster on Wall No. 2 of Shop No.116 of Ground floor

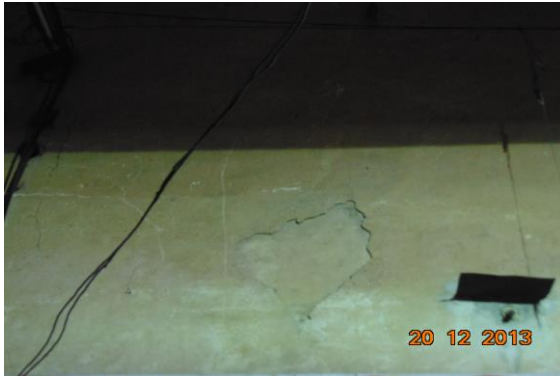
Photo 131
Plaster Crack on Front Wall of Shop No.116 of Ground floor
