Pre Building Condition Survey Report

Name and Address of Structure :	Choti Chopar to Badi Chopar (Down Line)
---------------------------------	---

Name of the Project	Contract JMRC-UG1B “Design and Construction of Tunnel between Chandpole and Badi Chouper and reverse line by Shield TBM, Underground Metro Stations at Choti Chouper and Badi Chouper by Cut and Cover Methods on East West Corridor of Jaipur Metro Rail Corporation Limited .”	
Owner :

Pre Building Condition Survey Report Choti Chopar to Badi Chopar (Down Line)

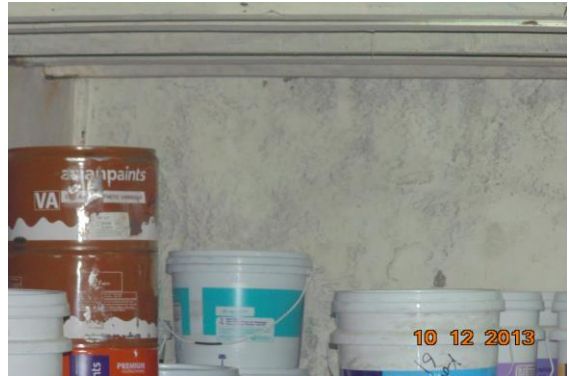
Photo 132
Dampness/Seepage on Wall No. 4 of Shop No.25 of Ground Floor

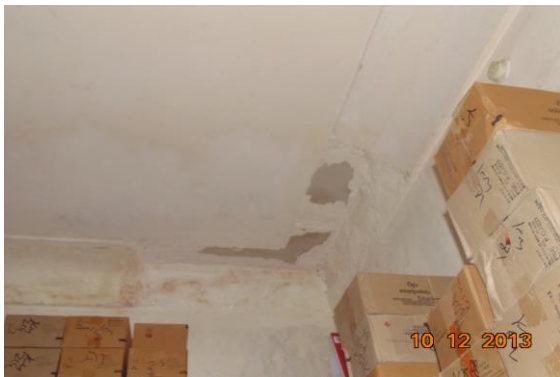
Photo 133
Dampness/Seepage on Wall No. 4 & Roof of Shop No.29 of Ground Floor

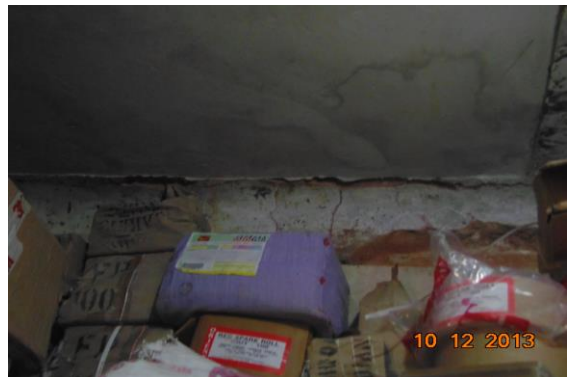
Photo 134
Peeling of Plaster on Wall No. 4 & Roof of Shop No.30 of Ground Floor

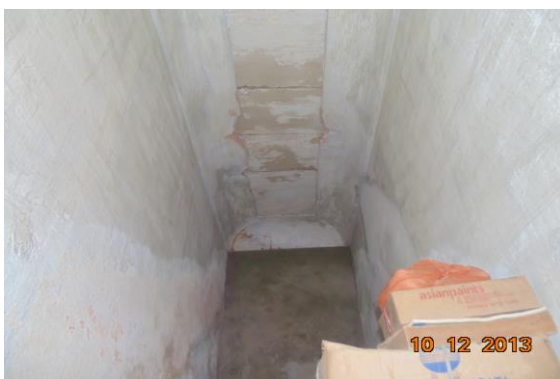
Photo 135
Dampness/Seepage on Wall No. 1 & Roof of Part-II of Shop No.31, Ground Floor

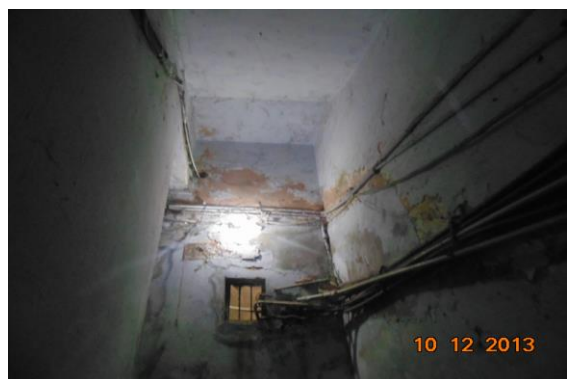
Photo 136
Dampness/Seepage on All Walls of Stair GF to FF of Ground Floor

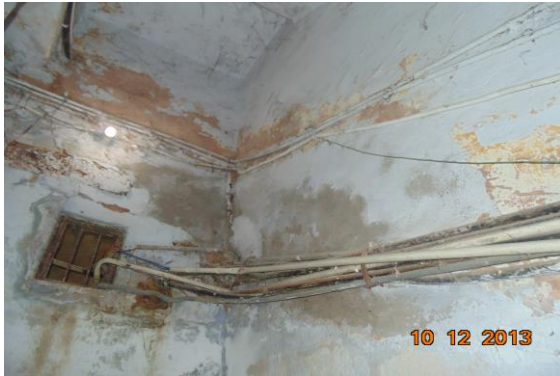
Photo 137
Dampness/Seepage on All Walls of Stair GF to FF of Ground Floor

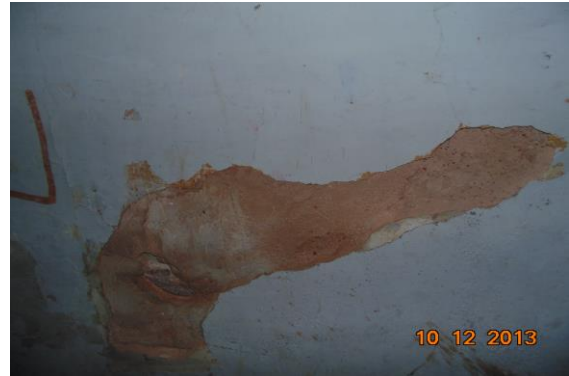
Photo 138
Peeling of Plaster on Wall No. 1 of Stair GF to FF of Ground Floor

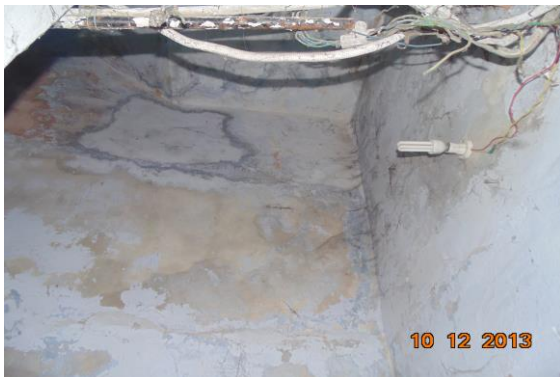
Photo 139
Dampness/Seepage on Wall No. 1 of Stair GF to FF of Ground Floor

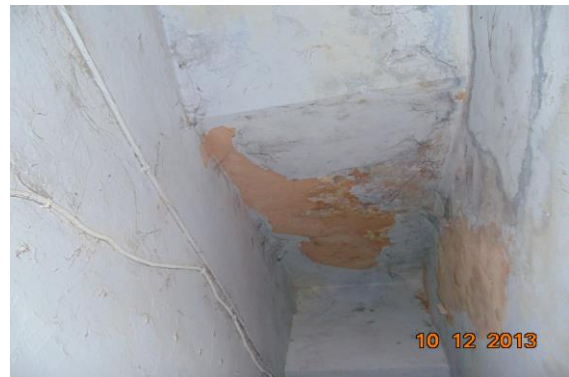
Photo 140
Peeling of Plaster on Roof of Stair GF to FF of Ground Floor

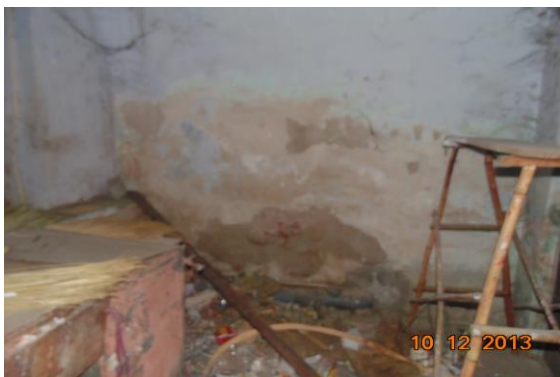
Photo 141
Peeling of Plaster on Wall No. 4 of Lobby of First Floor

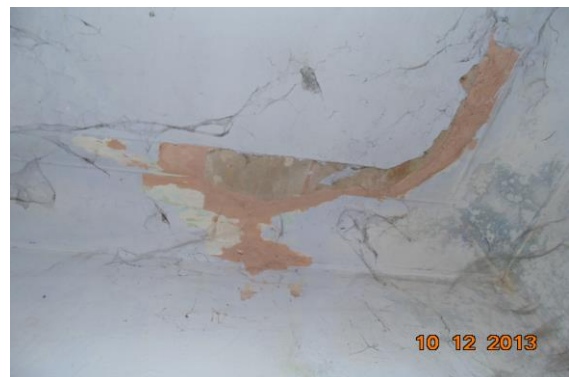
Photo 142
Peeling of Plaster on Roof of Lobby of First Floor

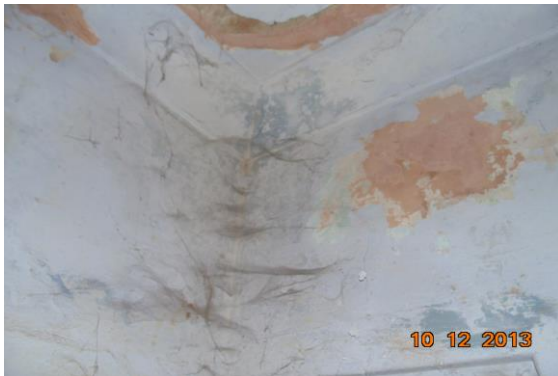
Photo 143
Dampness/Seepage on Wall No. 2 & 3 of Lobby of First Floor

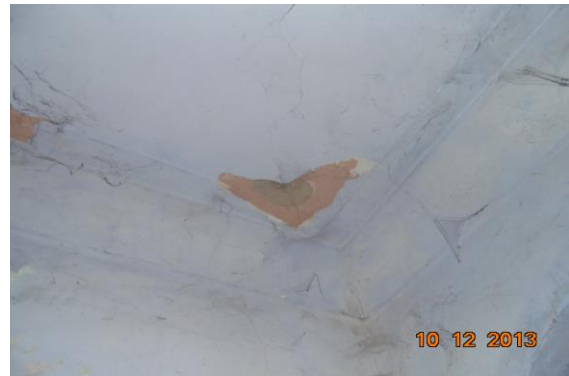
Photo 144
Peeling of Plaster on Roof of Lobby of First Floor

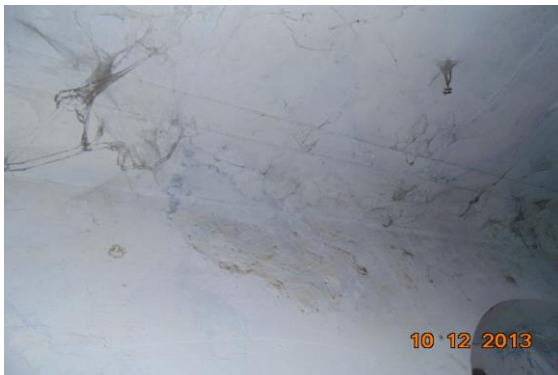
Photo 145
Dampness/Seepage on Wall No. 1 of Lobby of First Floor

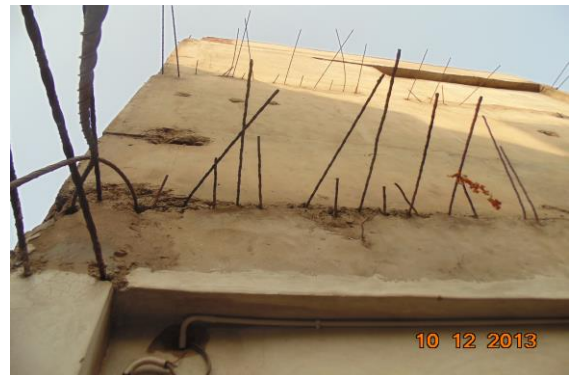
Photo 146
Exposed Reinforcement on Outer Wall of Shop No.10 of First Floor

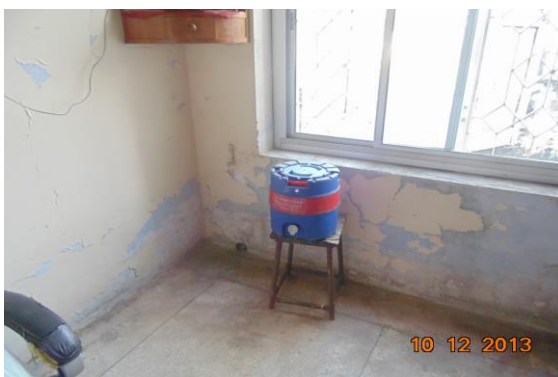
Photo 147
Peeling of Plaster on Wall No. 4 & 1 of Shop No.206 of Second Floor

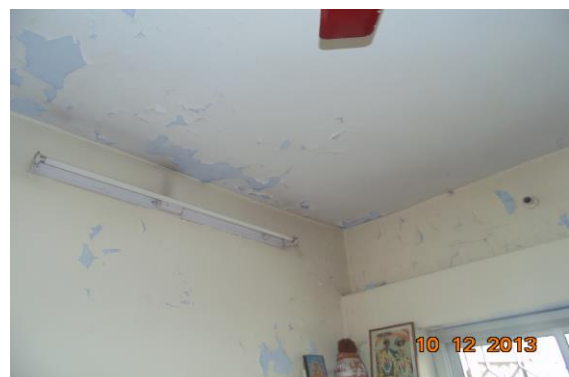
Photo 148
Peeling of Plaster on Wall No. 1, 4 & Roof of Shop No.206 of Second Floor

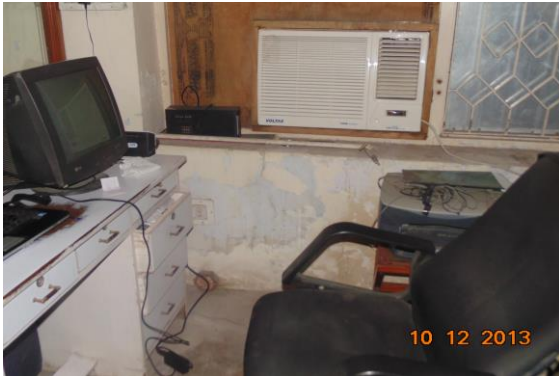
Photo 149
Peeling of Plaster on Wall No. 4 of Shop No.207 of Second Floor

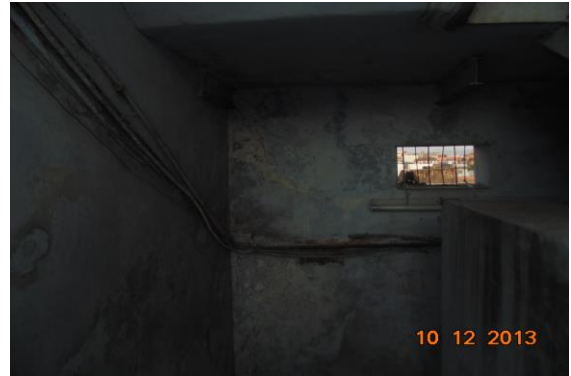
Photo 150
Dampness/Seepage on Wall No. 1, 2 & 4 of Staircase FF to SF of Second Floor

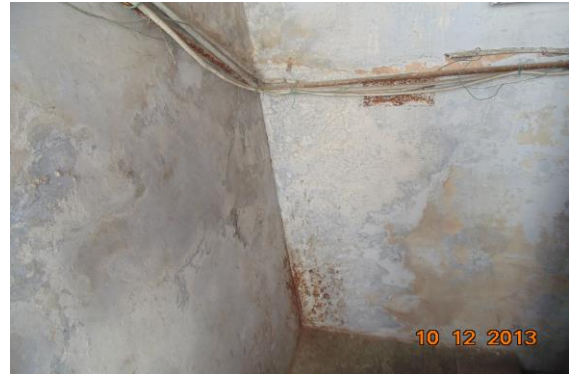
Photo 151
Dampness/Seepage on Wall No. 1, 2 & 4 of Staircase FF to SF of Second Floor

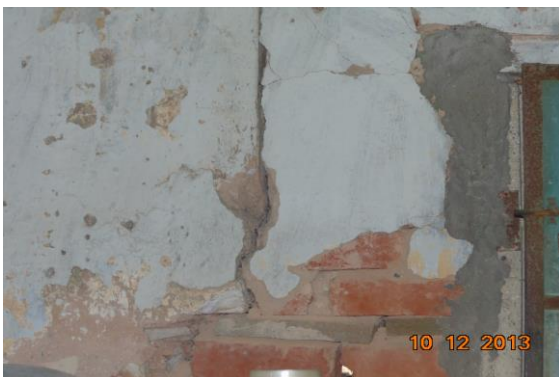
Photo 152
Dampness/Seepage on Wall No. 1, 2 & 4 of Staircase FF to SF of Second Floor

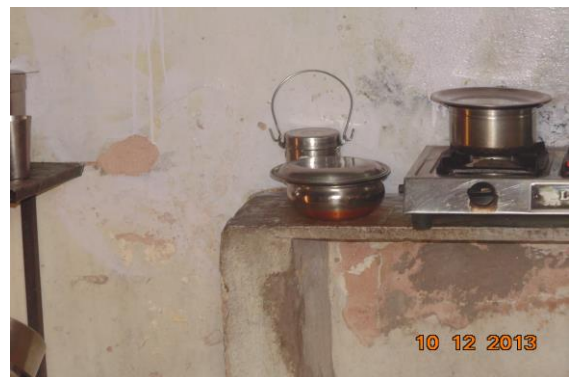
Photo 153
Damaged Portion on Wall No. 4 of Bathroom of Staircase FF to SF

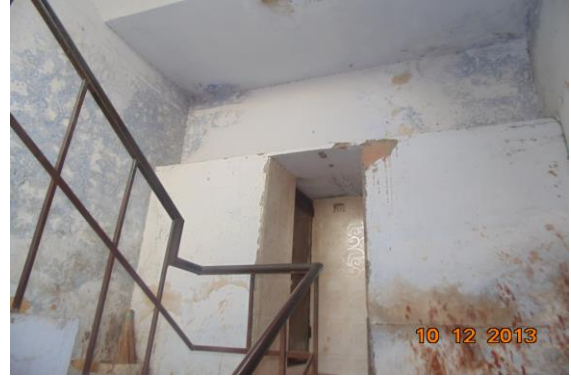
Photo 156
Dampness/Seepage on Wall No. 1, 2 & 4 of Staircase SF to TF of Second Floor

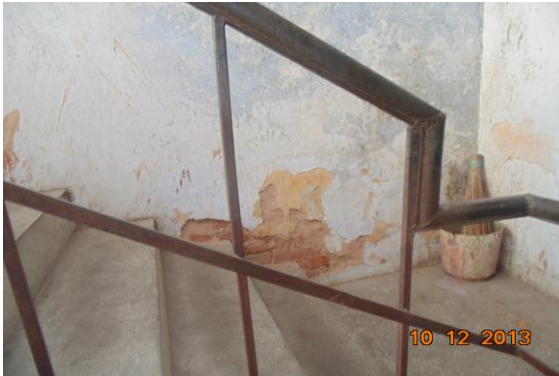
Photo 157
Peeling of Plaster on Wall No. 2 of Staircase SF to TF of Second Floor

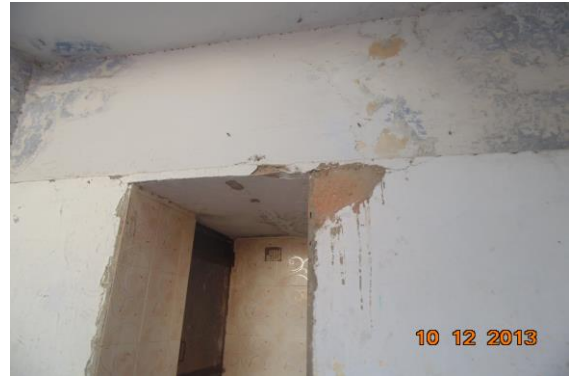
Photo 158
Peeling of Plaster on Wall No. 4 of Staircase SF to TF of Second Floor

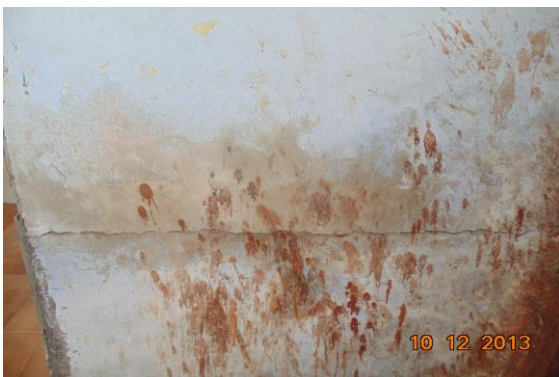
Photo 159
Peeling of Plaster on Wall No. 4 of Staircase SF to TF of Second Floor

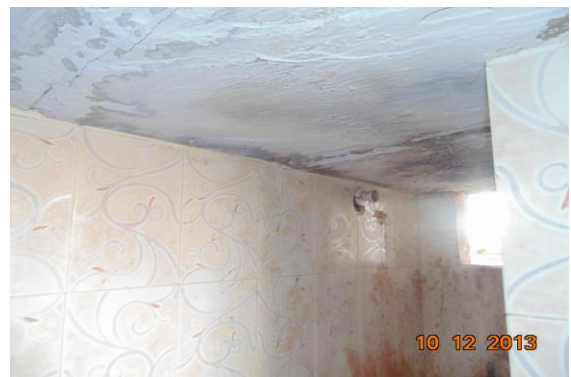
Photo 160
Dampness/Seepage on Roof of Toilet No. 1 of Second Floor

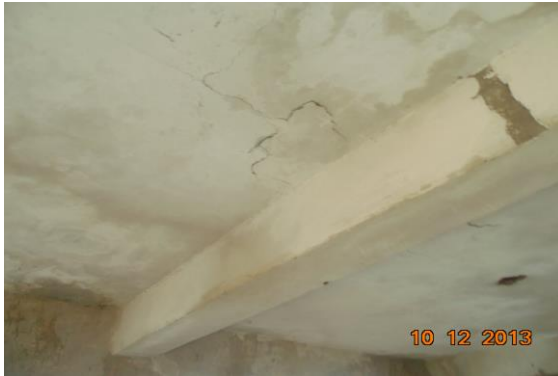
Photo 161
Peeling of Plaster on Roof of Shop No.305 of Third Floor

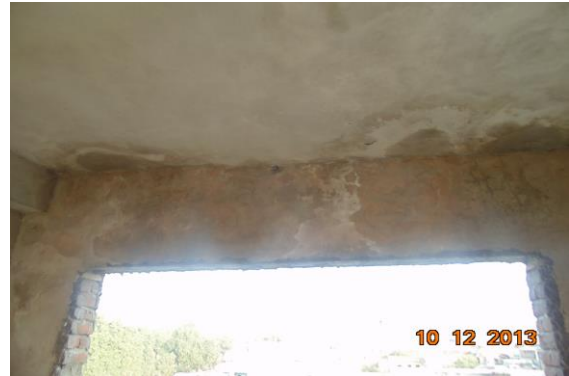
Photo 162
Dampness/Seepage on Wall No. 4 of Shop No.305 of Third Floor

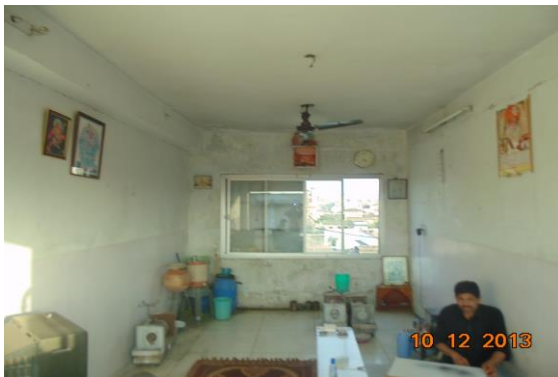
Photo 163
Dampness/Seepage on Wall No. 4 of Shop No.304 of Third Floor

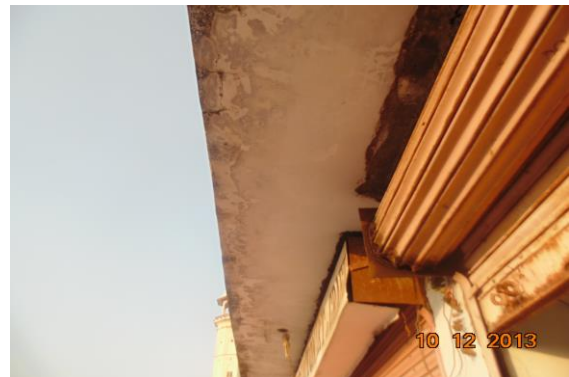
Photo 164
Dampness/Seepage on Shade Roof of Shop No.304 of Third Floor

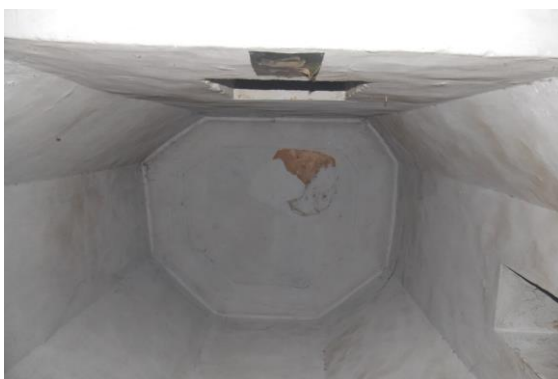
Photo 165
Damaged Portion on Roof of Tomb of First Floor

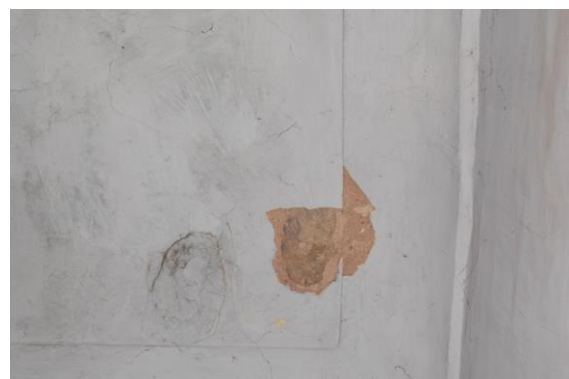
Photo 166
Damaged Portion on Roof of Room No. 1 of Temple First Floor

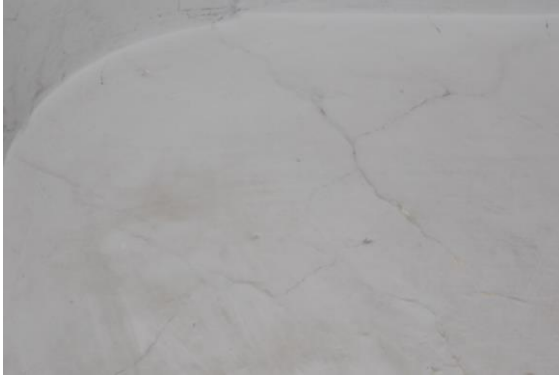
Photo 167
Peeling of Plaster on Wall No. 3 of Room No. 1 of Temple First Floor

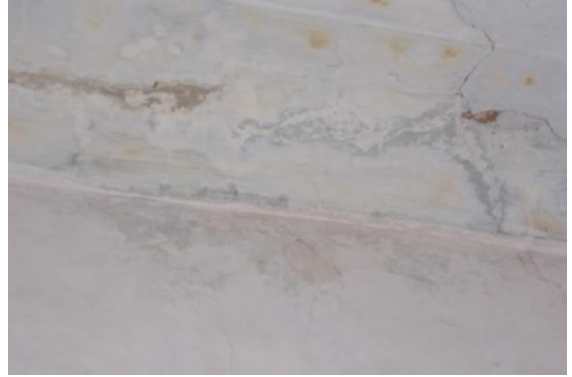
Photo 168
Dampness/Seepage on Wall No. 4 & Roof of Room No. 2 of Temple First Floor

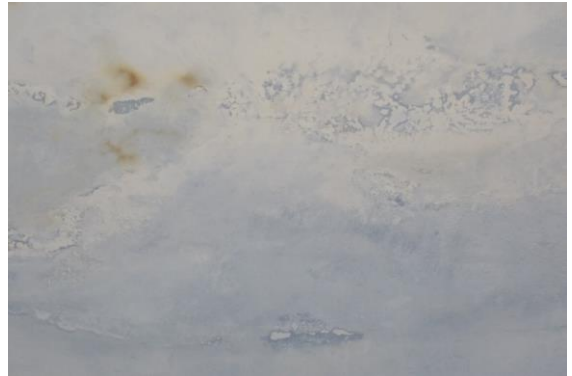
Photo 170
Peeling of Plaster on Roof of Lobby No.1 of Shri Krishna Chandra Ji Temple, First Floor

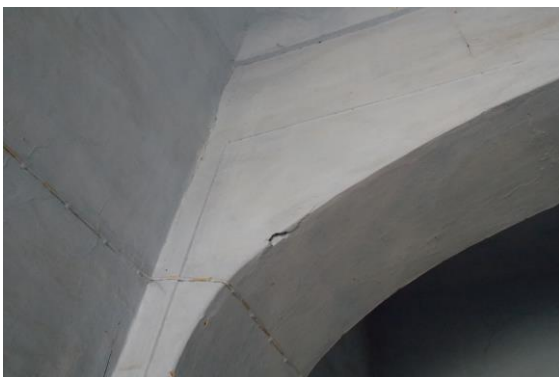
Photo 171
Peeling of Plaster on Roof of Lobby No.1 of Shri Krishna Chandra Ji Temple, First Floor

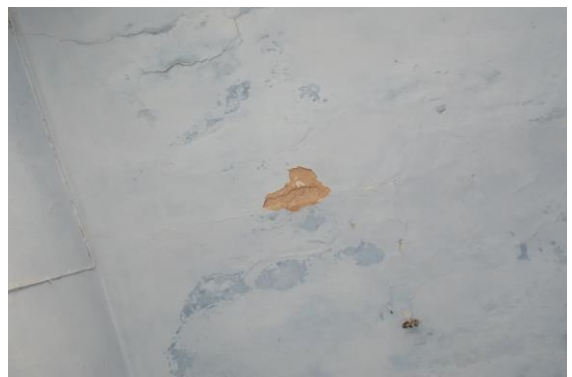
Photo 172
Peeling of Plaster on Roof of Lobby No.1 of Shri Krishna Chandra Ji Temple, First Floor

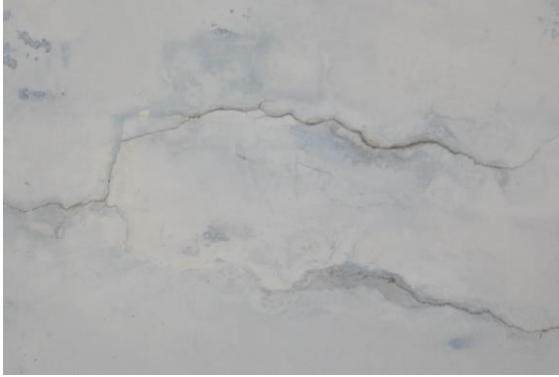
Photo 173

Peeling of Plaster on Roof of Lobby No.1 of Shri Krishna Chandra Ji Temple, First Floor

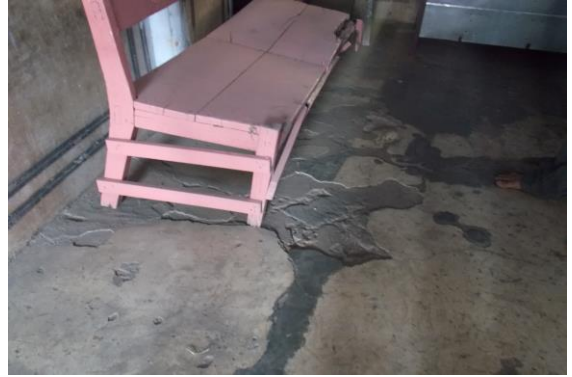
Photo 174

Peeling of Plaster on Floor of Lobby No.1 of Shri Krishna Chandra Ji Temple, First Floor

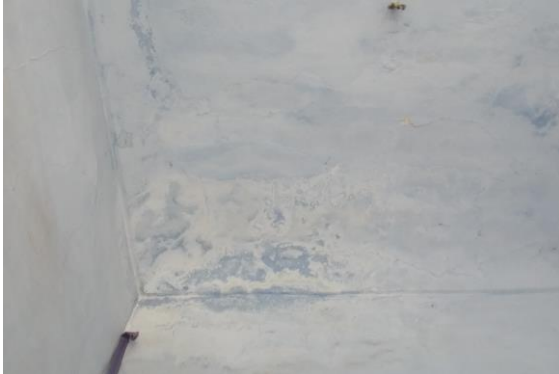
Photo 175

Dampness/Seepage on Roof of Lobby No.1 of Shri Krishna Chandra Ji Temple, First Floor

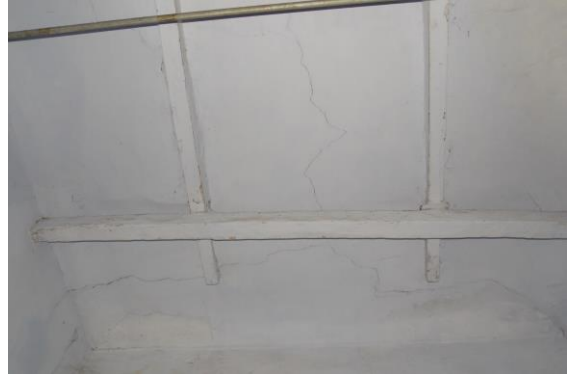
Photo 176

Damaged Portion on Roof of Room No. 3 of Shri Krishna Chandra Ji Temple, First Floor

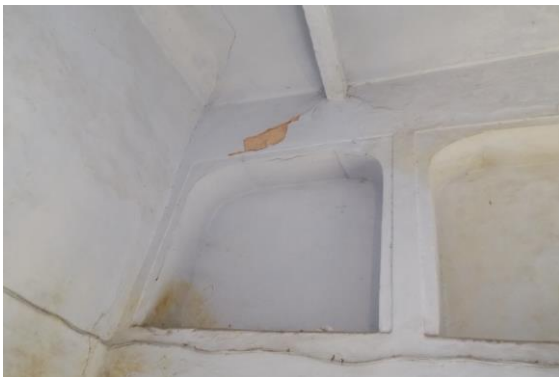
Photo 177

Peeling of Plaster on Wall No. 4 of Room No. 3 of Shri Krishna Chandra Ji Temple, First Floor

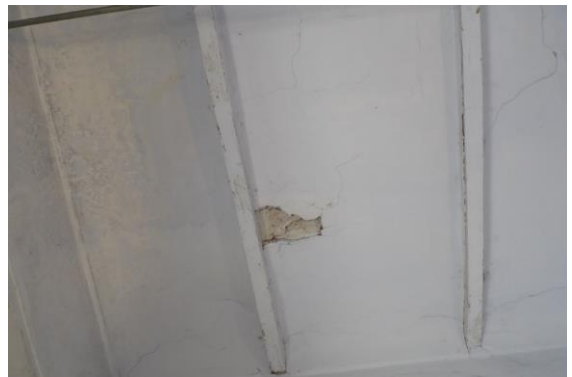
Photo 178

Peeling of Plaster on Roof of Room No. 3 of Shri Krishna Chandra Ji Temple, First Floor

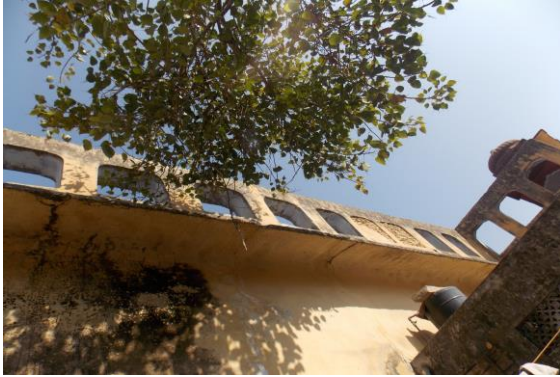
Photo 179

Damaged Portion on Roof Shade of Shri Krishna Chandra Ji Temple of First Floor

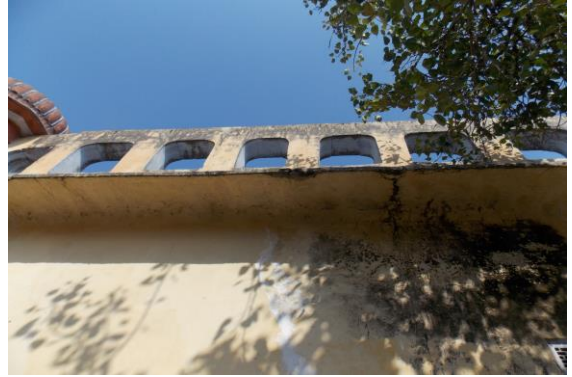
Photo 180

Damaged Portion on Roof Shade of Shri Krishna Chandra Ji Temple of First Floor

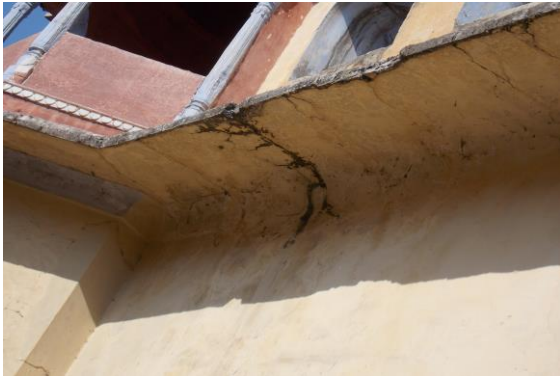
Photo 181

Damaged Portion on Roof Shade of Shri Krishna Chandra Ji Temple of First Floor

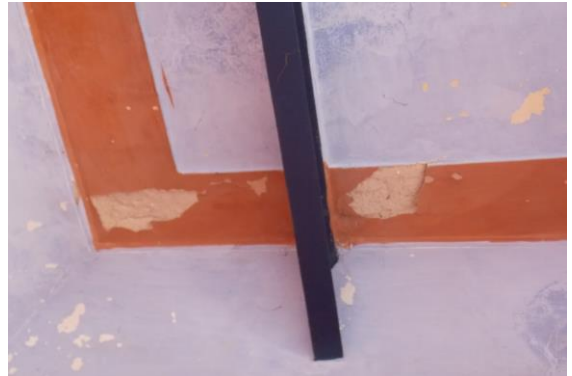
Photo 182

Peeling of Plaster on Roof of Lobby No.2 of Shri Krishna Chandra Ji Temple, First Floor

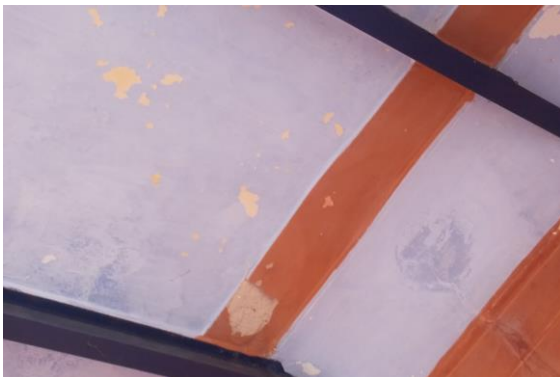
Photo 183

Dampness/Seepage on Roof of Lobby No.2 of Shri Krishna Chandra Ji Temple, First Floor

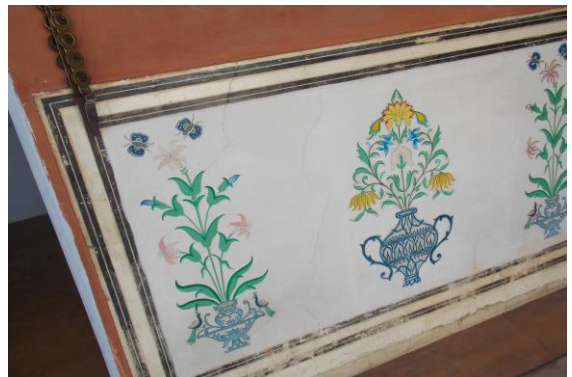
Photo 184

Peeling of Plaster on Wall No. 4 of Lobby No.2 of Shri Krishna Chandra Ji Temple, First Floor

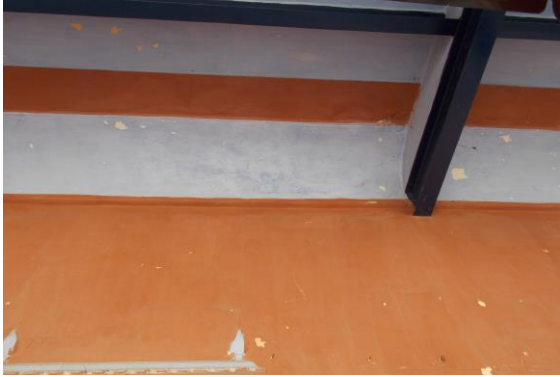
Photo 185

Dampness/Seepage on Wall No. 4 of Lobby No.2 of Shri Krishna Chandra Ji Temple, First Floor

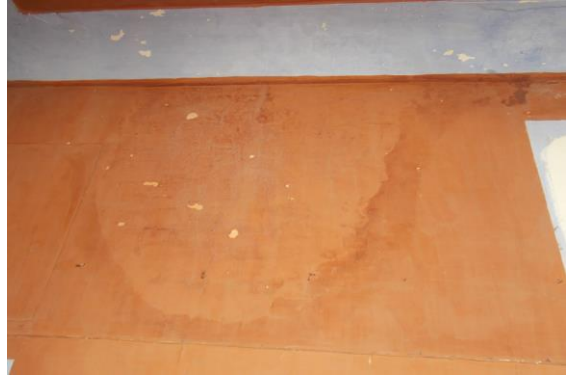
Photo 186

Dampness/Seepage on Wall No. 4 of Lobby No.2 of Shri Krishna Chandra Ji Temple, First Floor

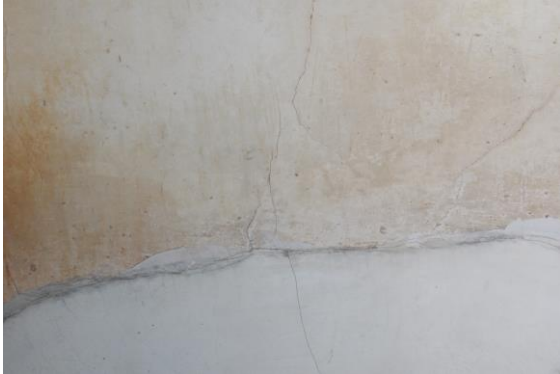
Photo 187

Peeling of Plaster on Wall No. 4 of Lobby No.2 of Shri Krishna Chandra Ji Temple, First Floor

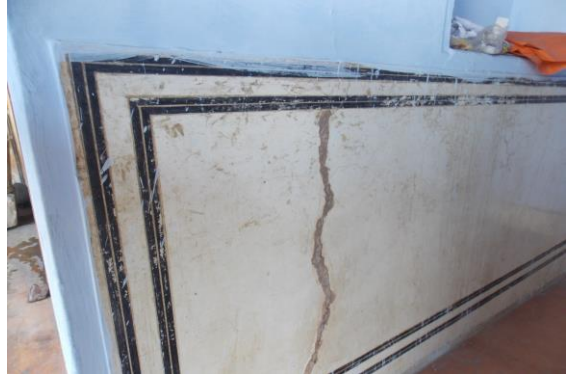
Photo 188

Peeling of Plaster on Wall No. 1 of Varanda No.1 of Shri Krishna Chandra Ji Temple, First Floor

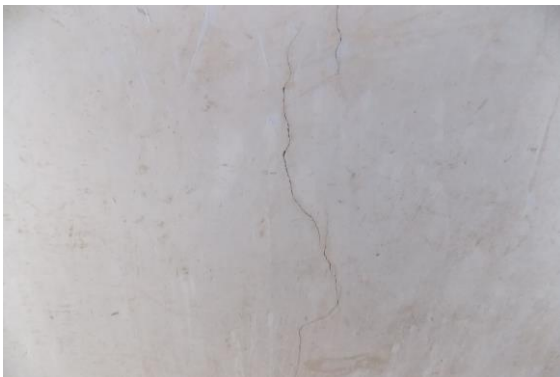
Photo 189

Peeling of Plaster on Wall No. 1 of Varanda No.1 of Shri Krishna Chandra Ji Temple, First Floor

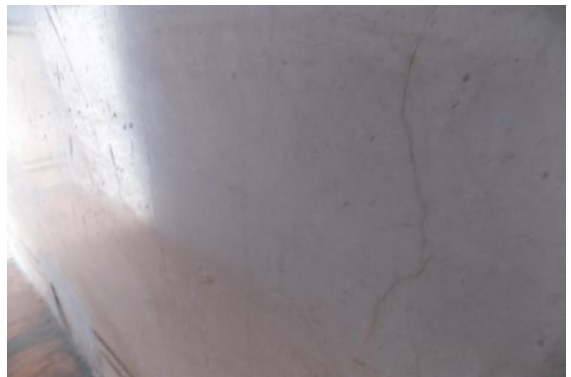
Photo 190

Peeling of Plaster on Wall No. 2 of Varanda No.2 of Shri Krishna Chandra Ji Temple, First Floor

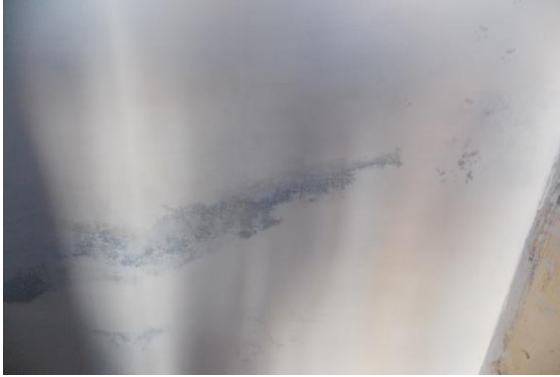
Photo 191

Dampness/Seepage on Wall No. 1 of Varanda No.2 of Shri Krishna Chandra Ji Temple, First Floor

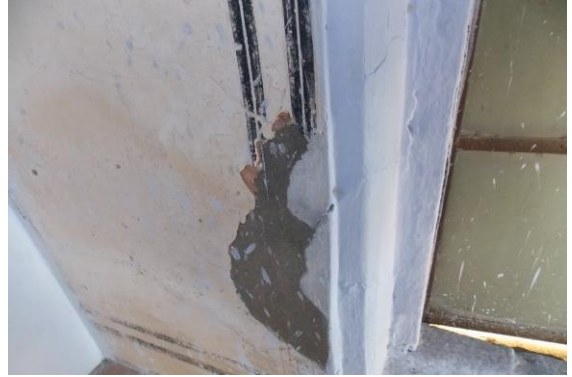
Photo 192

Peeling of Plaster on Wall No. 1 of Varanda No.3 of Shri Krishna Chandra Ji Temple, First Floor

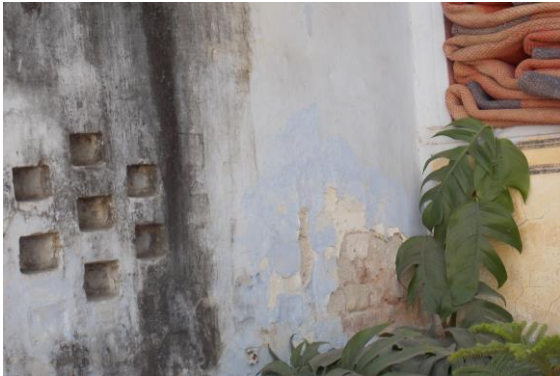
Photo 193

Peeling of Plaster on Wall No.3 & Outer Wall of Open to Sky Area No.3 of Shri Krishna Chandra Ji Temple, First Floor

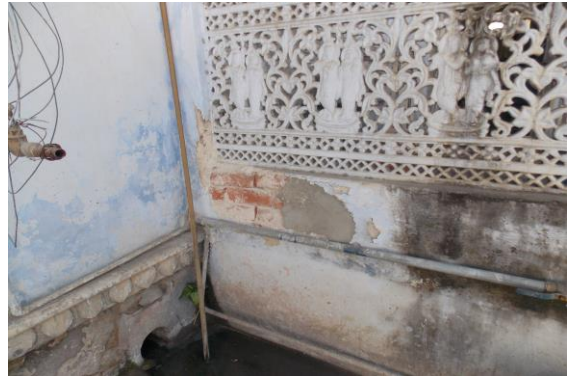
Photo 194

Peeling of Plaster on Wall No. 3 & Outer Wall of Open to Sky Area No.3 of Shri Krishna Chandra Ji Temple, First Floor

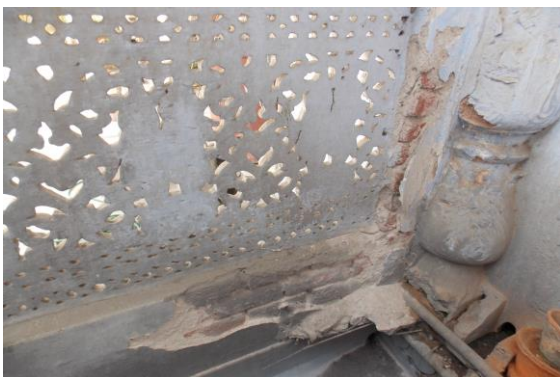
Photo 195

Damaged Portion on Wall No. 3 of Open to Sky Area No.3 of Shri Krishna Chandra Ji Temple, First Floor

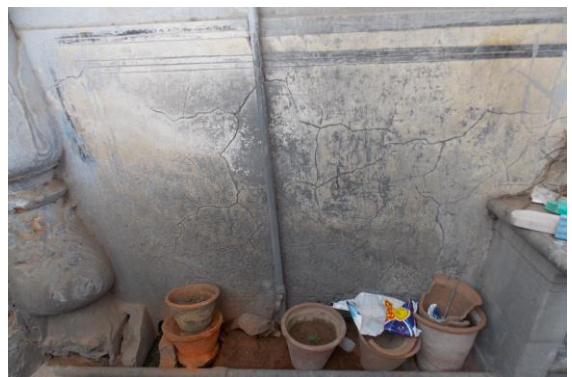
Photo 196

Peeling of Plaster on Wall No. 1 of Open to Sky Area No.3 of Shri Krishna Chandra Ji Temple, First Floor

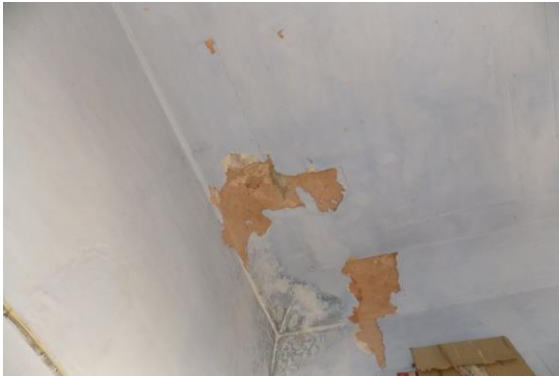
Photo 197

Peeling of Plaster on Roof of Room No. 6 of Open to Sky Area No.3 Shri Krishna Chandra Ji Temple, First Floor

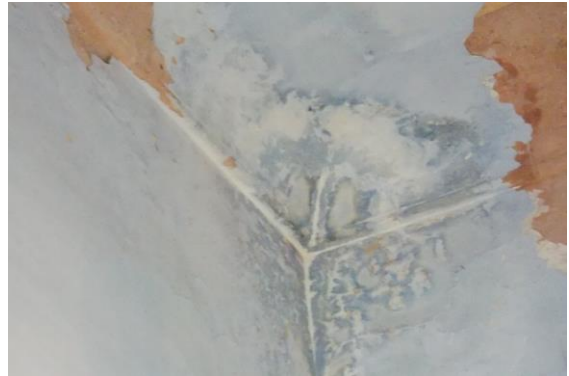
Photo 198

Dampness/Seepage on Wall No. 1, 4 & Roof of Room No. 6 of Open to Sky Area No.3 Shri Krishna Chandra Ji Temple, First Floor

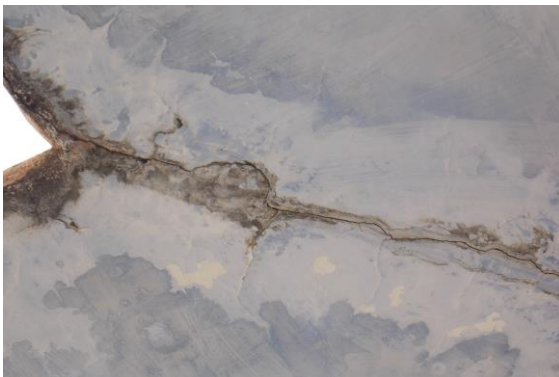
Photo 199

Damaged Portion on Roof Shade of Shri Krishna Chandra Ji Temple of First Floor

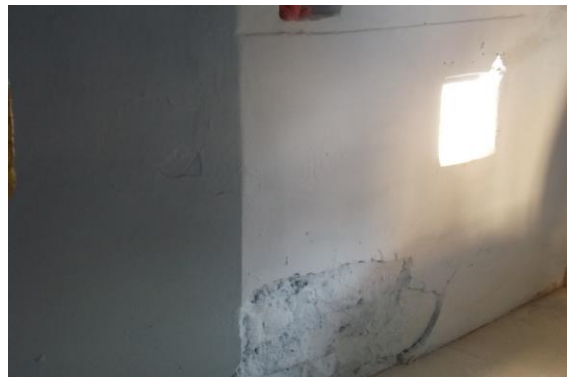
Photo 200

Peeling of Plaster of Toilet No. 1 of Shri Krishna Chandra Ji Temple First Floor

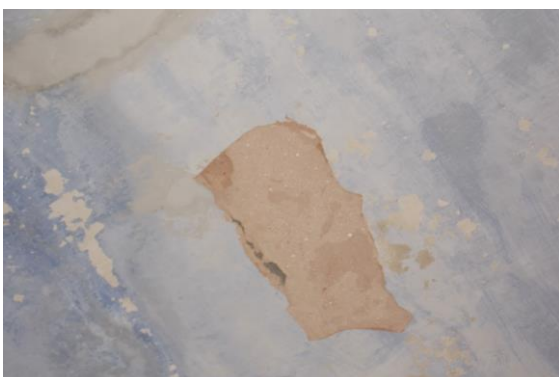
Photo 201

Peeling of Plaster on Roof of Lobby No.4 of Shri Krishna Chandra Ji Temple, First Floor

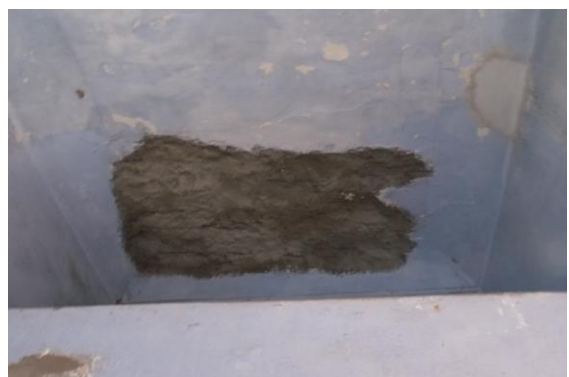
Photo 202

Peeling of Plaster on Roof of Lobby No.4 of Shri Krishna Chandra Ji Temple, First Floor

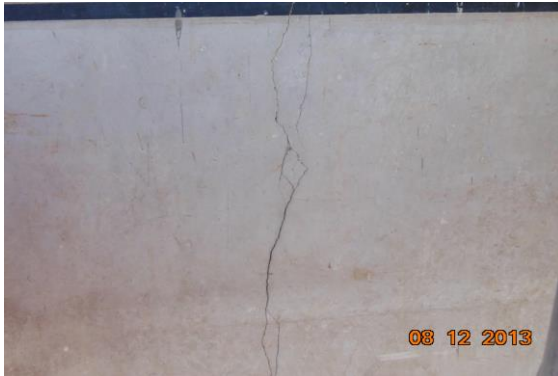
Photo 203

Peeling of Plaster on Wall No. 4 of Lobby No.4 of Shri Krishna Chandra Ji Temple, First Floor

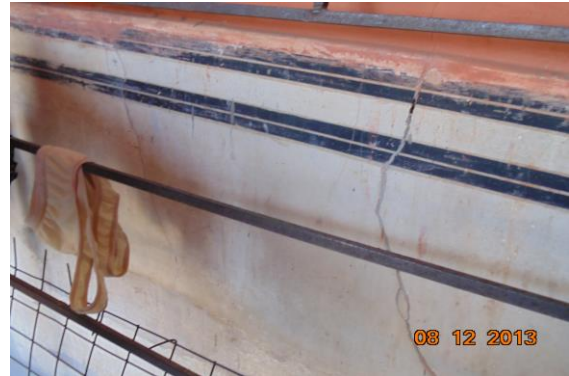
Photo 204

Peeling of Plaster on Wall No. 4 of Lobby No.4 of Shri Krishna Chandra Ji Temple, First Floor

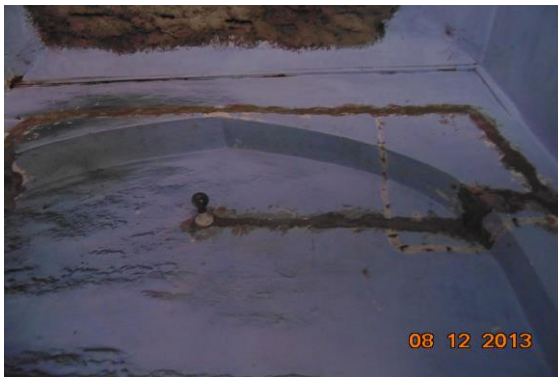
Photo 205

Peeling of Plaster on Wall No. 2 of Kitchen of Shri Krishna Chandra Ji Temple, First Floor

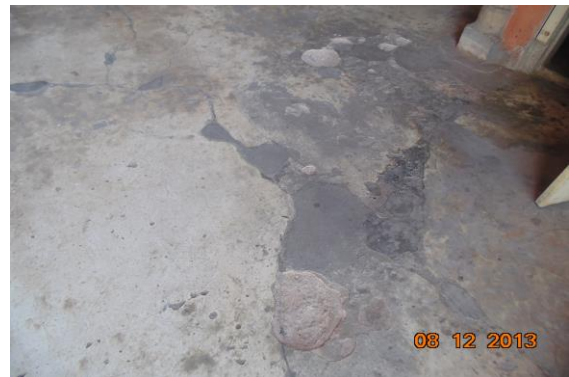
Photo 206

Damaged Portion on Floor of Lobby No.4 of Shri Krishna Chandra Ji Temple, First Floor

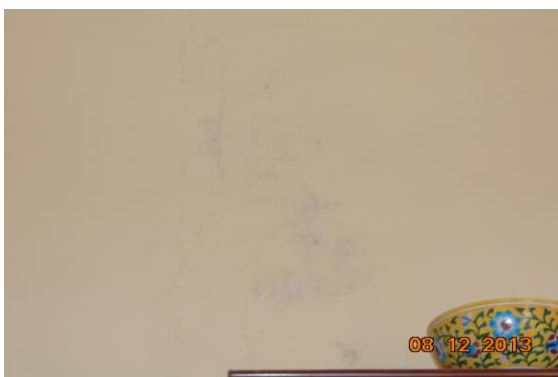
Photo 207

Peeling of Plaster on Wall No. 4 of Room No. 7 of Shri Krishna Chandra Ji Temple First Floor

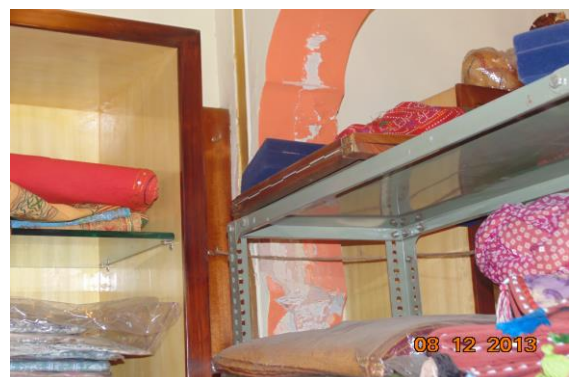
Photo 208

Peeling of Plaster on Wall No. 7 of Room No. 7 of Shri Krishna Chandra Ji Temple First Floor

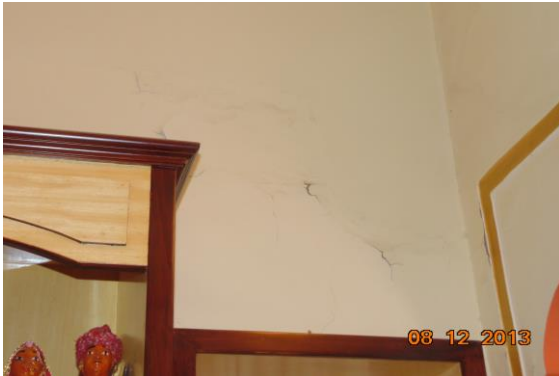
Photo 209

Peeling of Plaster on Wall No. 7 of Room No. 7 of Shri Krishna Chandra Ji Temple First Floor

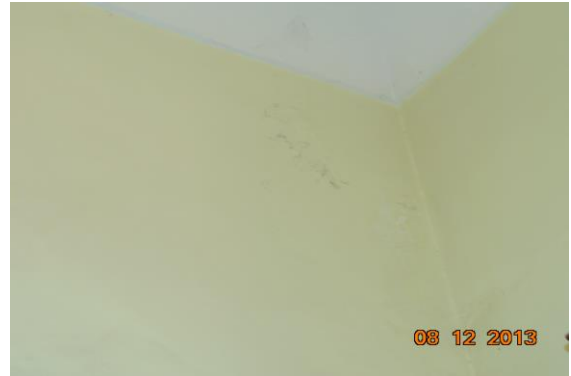
Photo 210

Dampness/Seepage on Wall No. 1 of Room No. 7 of Shri Krishna Chandra Ji Temple First Floor

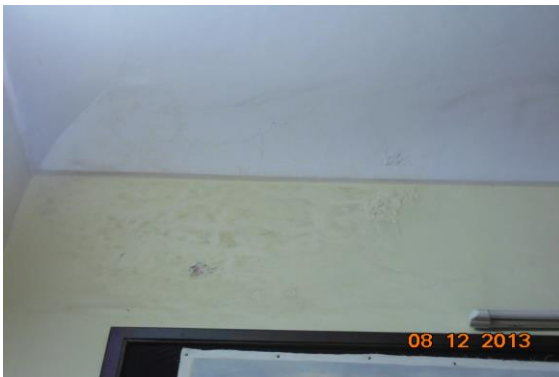
Photo 211

Dampness/Seepage on Wall No. 4 & Roof of Room No. 8 of Shri Krishna Chandra Ji Temple First Floor

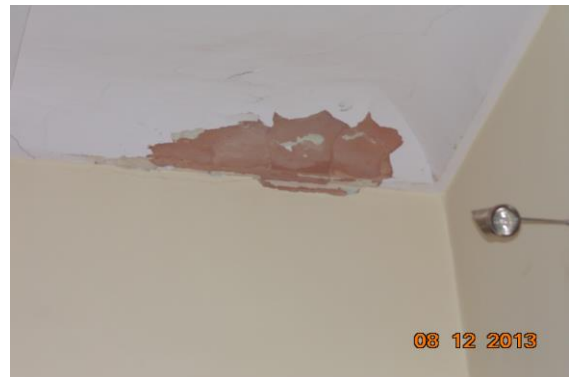
Photo 212

Peeling of Plaster on Wall No. 2 of Room No. 8 of Shri Krishna Chandra Ji Temple First Floor

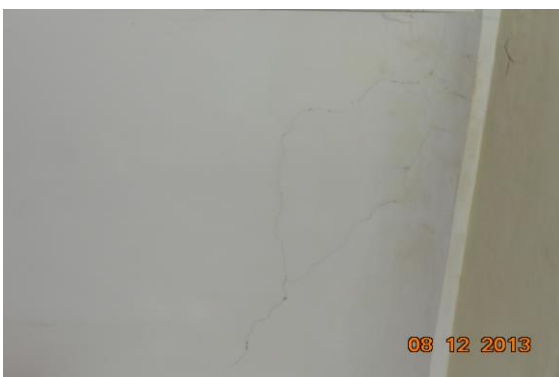
Photo 213

Peeling of Plaster on Roof of Room No. 8 of Shri Krishna Chandra Ji Temple First Floor

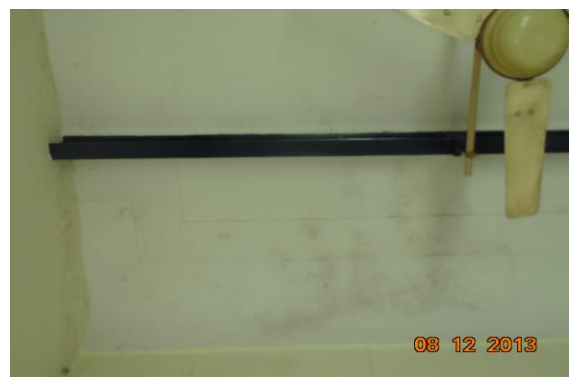
Photo 214

Dampness/Seepage on Roof of Room No. 10 of Shri Krishna Chandra Ji Temple First Floor

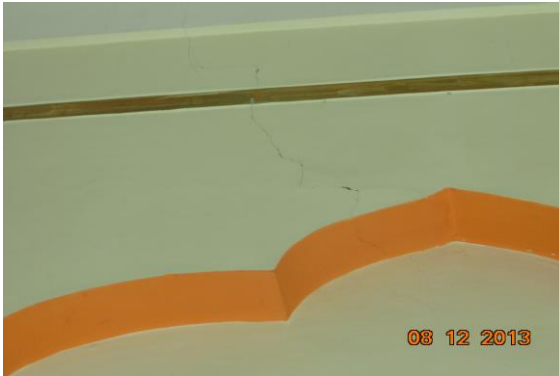
Photo 215

Peeling of Plaster on Wall No. 3 of Room No. 10 of Shri Krishna Chandra Ji Temple First Floor

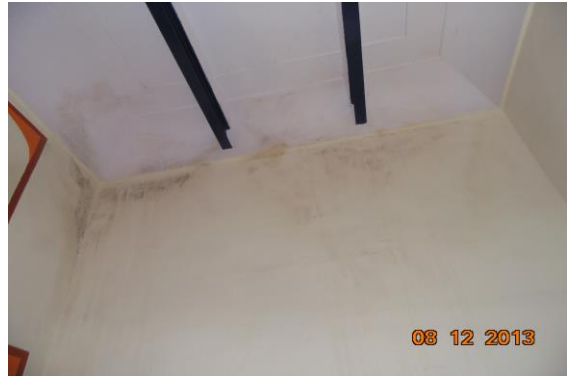
Photo 216

Dampness/Seepage on Wall No. 1, 4 & Roof of Room No. 9 of Shri Krishna Chandra Ji Temple First Floor

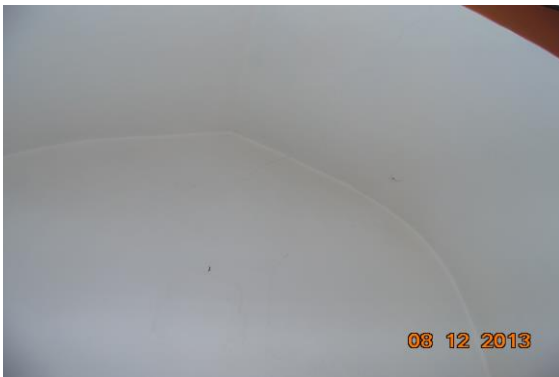
Photo 217

Peeling of Plaster on Wall No. 1 of Room No. 9 of Shri Krishna Chandra Ji Temple First Floor

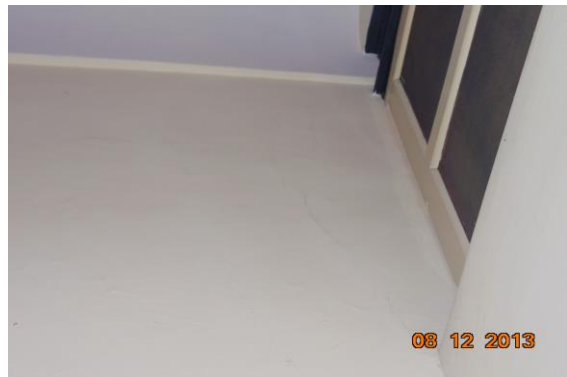
Photo 218

Peeling of Plaster on Wall No. 2 of Room No. 9 of Shri Krishna Chandra Ji Temple First Floor

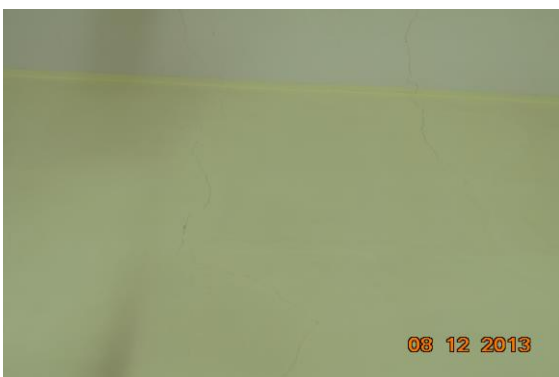
Photo 219

Peeling of Plaster on Wall No. 4 of Room No. 11 of Shri Krishna Chandra Ji Temple First Floor

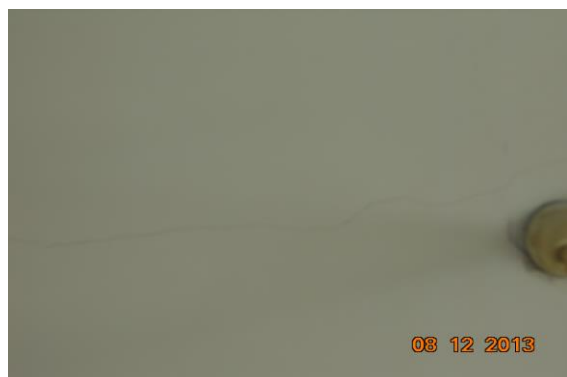
Photo 220

Peeling of Plaster on Roof of Room No. 11 of Shri Krishna Chandra Ji Temple First Floor

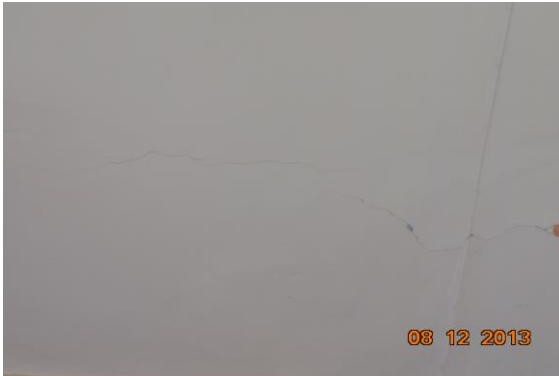
Photo 221

Peeling of Plaster on Roof of Room No. 11 of Shri Krishna Chandra Ji Temple First Floor

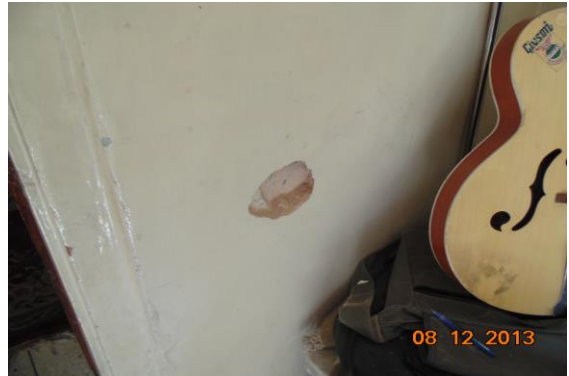
Photo 222

Peeling of Plaster on Wall No. 1 of Room No. 11 of Shri Krishna Chandra Ji Temple First Floor

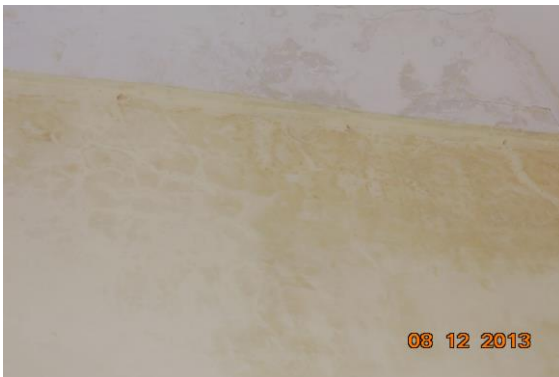
Photo 223

Dampness/Seepage on Wall No. 4 & Roof of Room No. 12 of Shri Krishna Chandra Ji Temple First Floor

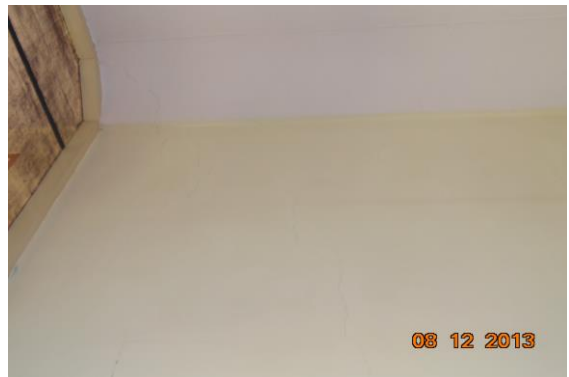
Photo 224

Peeling of Plaster on Wall No. 1 of Room No. 12 of Shri Krishna Chandra Ji Temple First Floor

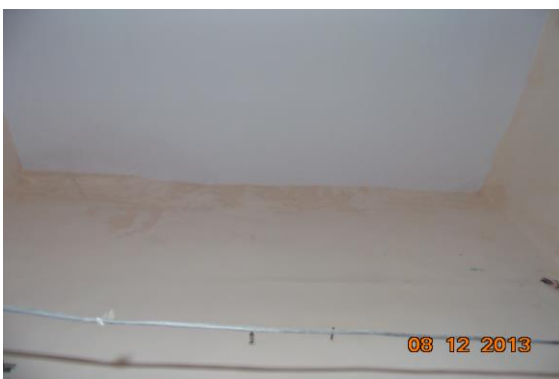
Photo 225

Dampness/Seepage on Wall No. 4 of Toilet No. 2 of Shri Krishna Chandra Ji Temple First Floor

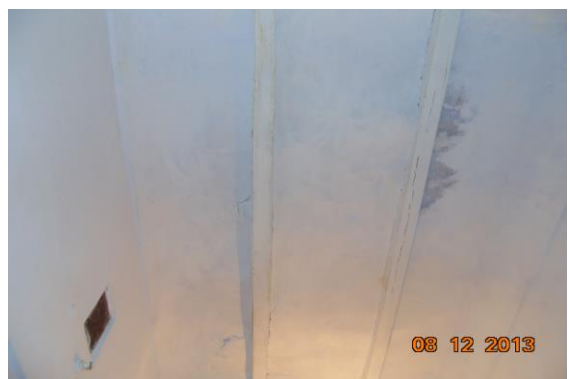
Photo 226

Damaged Portion on Roof of Room No. 13 of Shri Krishna Chandra Ji Temple First Floor

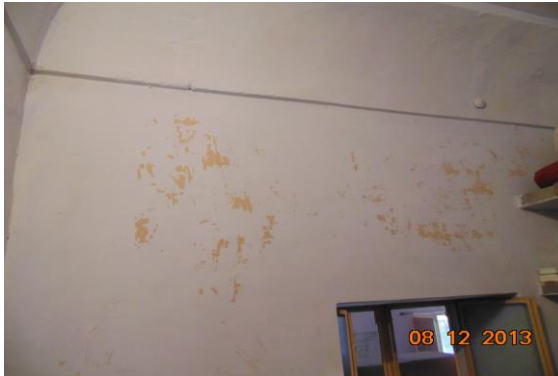
Photo 227

Peeling of Plaster on Wall No. 1 & 2 of Store of Shri Krishna Chandra Ji Temple, First Floor

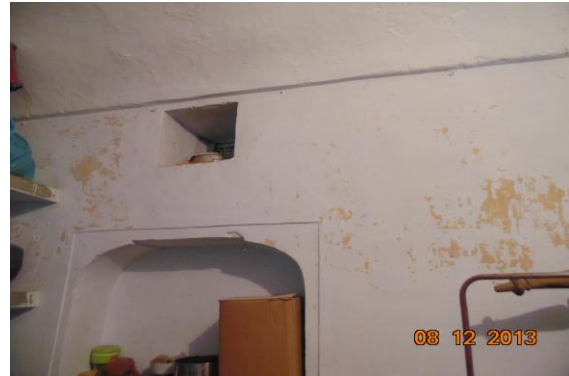
Photo 228

Peeling of Plaster on Wall No. 1 & 2 of Store of Shri Krishna Chandra Ji Temple, First Floor

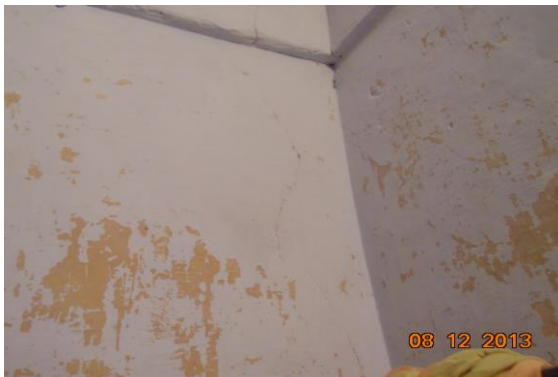
Photo 229

Plaster Crack on Wall No. 2 of Store of Shri Krishna Chandra Ji Temple, First Floor

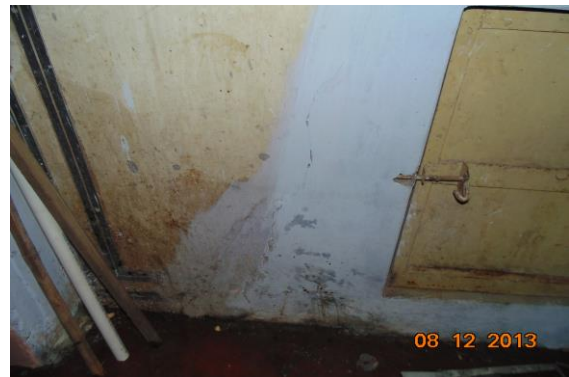
Photo 230

Peeling of Plaster on Wall No. 1 of Room No. 13 of Shri Krishna Chandra Ji Temple First Floor
