Pre Building Condition Survey Report

Name and Address of Structure :	Choti Chopar to Badi Chopar (Down Line)
---------------------------------	---

Name of the Project	Contract JMRC-UG1B “Design and Construction of Tunnel between Chandpole and Badi Chouper and reverse line by Shield TBM, Underground Metro Stations at Choti Chouper and Badi Chouper by Cut and Cover Methods on East West Corridor of Jaipur Metro Rail Corporation Limited .”	
Owner :

Pre Building Condition Survey Report Choti Chopar to Badi Chopar (Down Line)

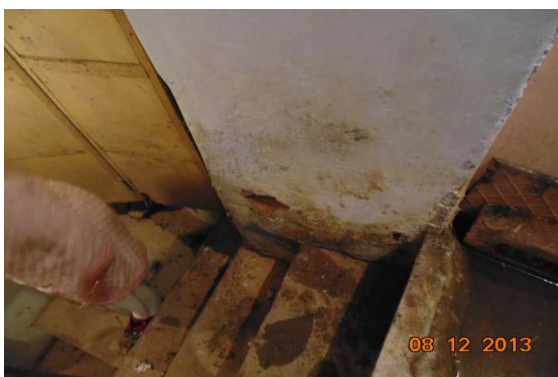
Photo 231

Peeling of Plaster on Wall No. 1 of Staircase GF to FF of Shri Krishna Chandra Ji Temple, Ground Floor

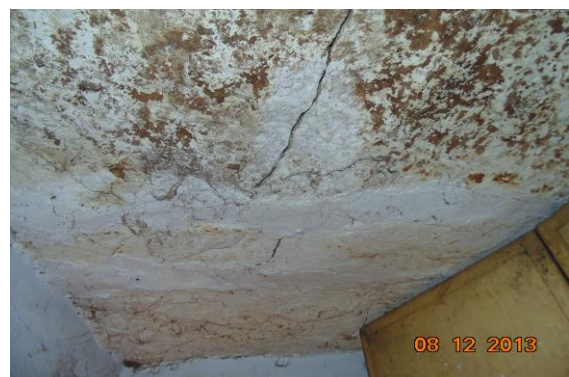
Photo 232

Damaged Portion on Roof of Staircase GF to FF of Shri Krishna Chandra Ji Temple, Ground Floor

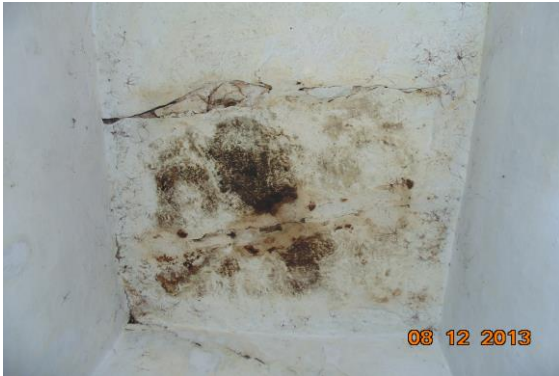
Photo 233

Damaged Portion on Roof of Staircase GF to FF of Shri Krishna Chandra Ji Temple, Ground Floor

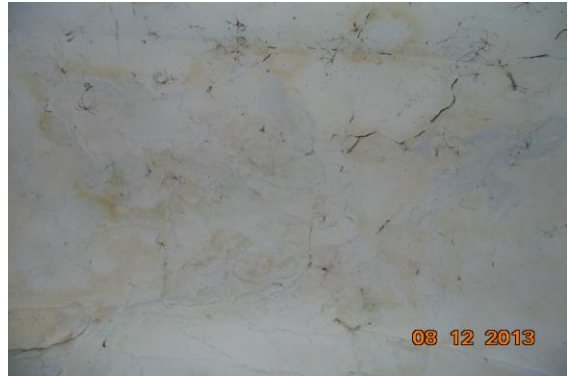
Photo 234

Peeling of Plaster on Roof of Room No. 1 of Shri Krishna Chandra Ji Temple Ground Floor

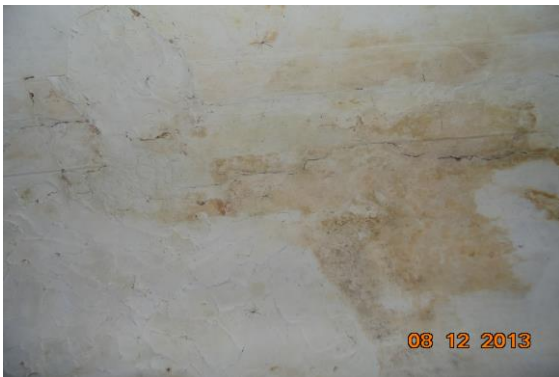
Photo 235

Peeling of Plaster on Roof of Room No. 1 of Shri Krishna Chandra Ji Temple Ground Floor

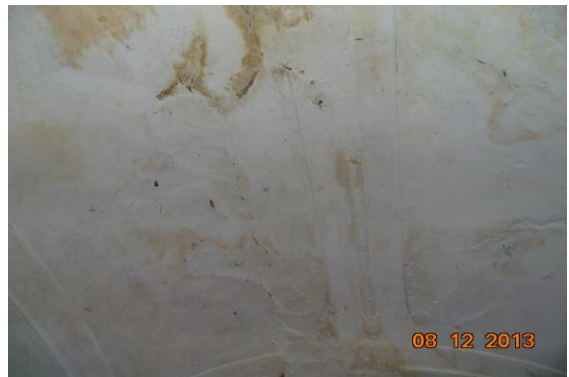
Photo 236

Peeling of Plaster on Roof of Room No. 1 of Shri Krishna Chandra Ji Temple Ground Floor

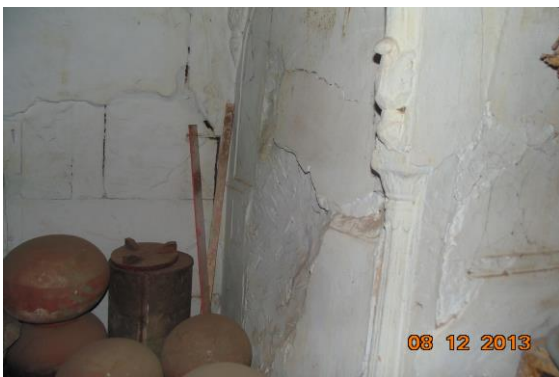
Photo 237

Peeling of Plaster on Wall No. 2 of Room No. 1 of Shri Krishna Chandra Ji Temple Ground Floor

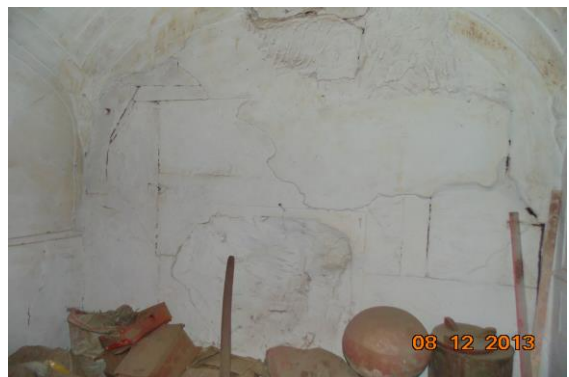
Photo 238

Peeling of Plaster on Wall No. 2 of Room No. 1 of Shri Krishna Chandra Ji Temple Ground Floor

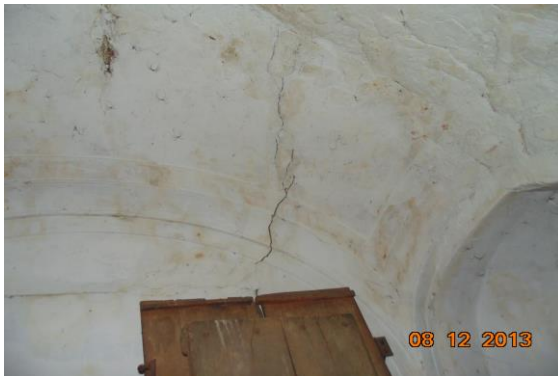
Photo 239

Damaged Portion on Wall No. 4 & Roof of Room No. 1 of Shri Krishna Chandra Ji Temple Ground Floor

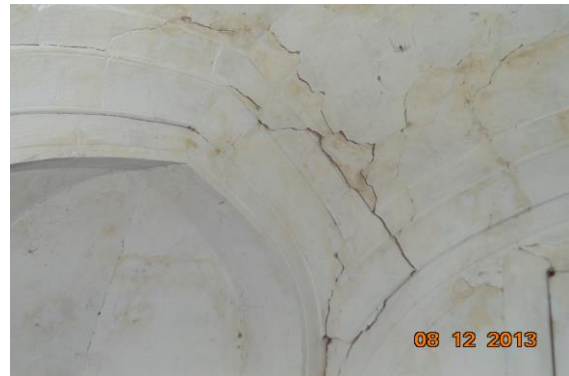
Photo 240

Damaged Portion on Wall No. 4 & Roof of Room No. 1 of Shri Krishna Chandra Ji Temple Ground Floor

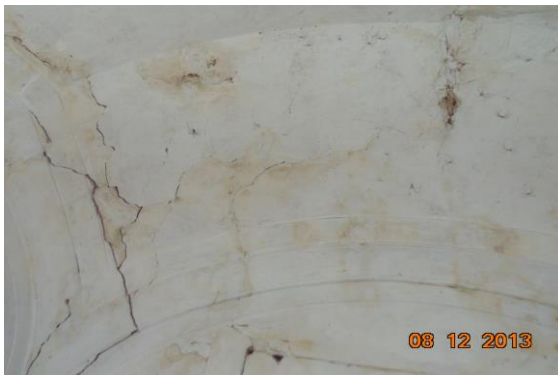
Photo 241

Damaged Portion on Wall No. 4 & Roof of Room No. 1 of Shri Krishna Chandra Ji Temple Ground Floor

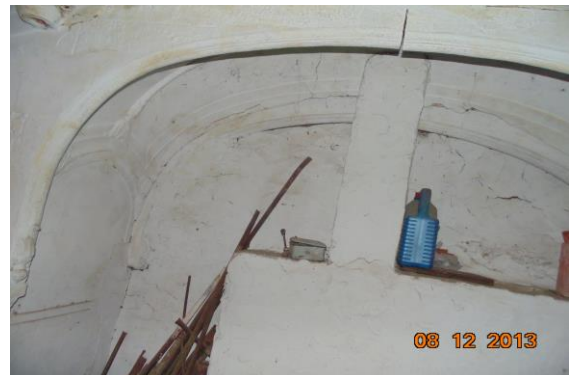
Photo 242

Peeling of Plaster on Wall No. 2 of Room No. 1 of Shri Krishna Chandra Ji Temple Ground Floor

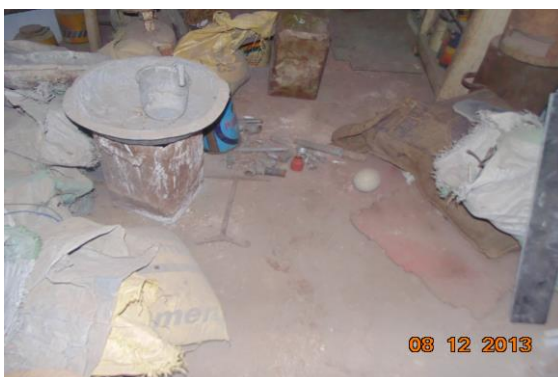
Photo 243

Damaged Portion on Floor of Room No. 1 of Shri Krishna Chandra Ji Temple Ground Floor

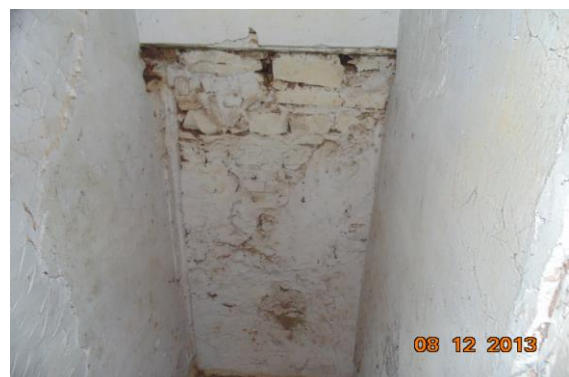
Photo 244

Damaged Portion on Wall No. 4 of Staircase GF to FF of Shri Krishna Chandra Ji Temple, Ground Floor

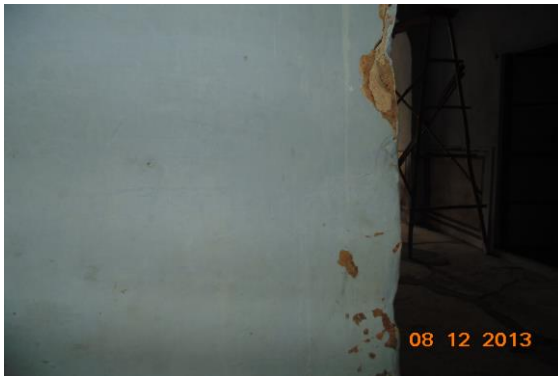
Photo 245

Peeling of Plaster on Wall No. 2 of Lobby No.3 of Shri Krishna Chandra Ji Temple, First Floor

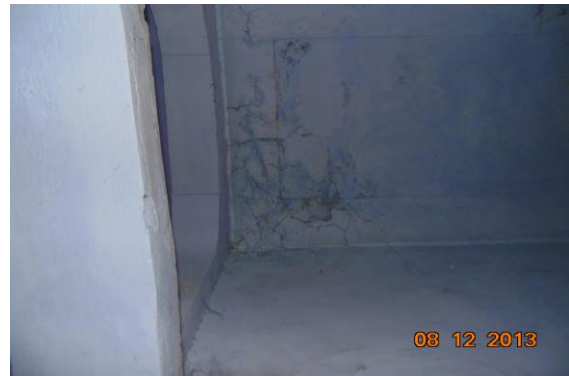
Photo 246

Dampness/Seepage on Roof of Lobby No.3 of Shri Krishna Chandra Ji Temple, First Floor

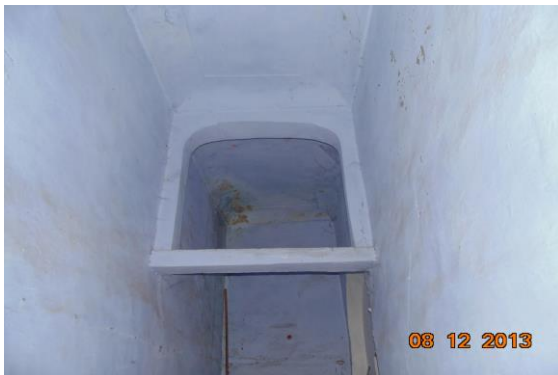
Photo 247

Dampness/Seepage on Wall No. 1 & Roof of Lobby No.3 of Shri Krishna Chandra Ji Temple, First Floor

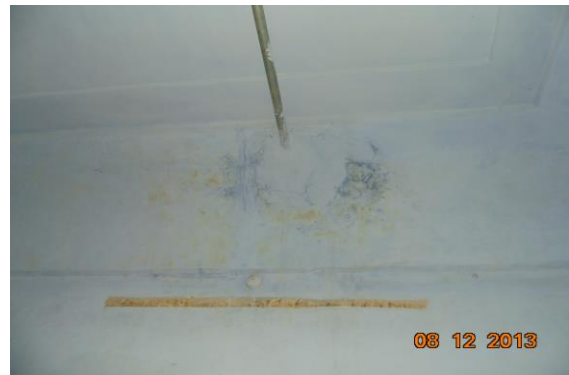
Photo 248

Dampness/Seepage on Wall No. 2 of Room No. 16 of Shri Krishna Chandra Ji Temple First Floor

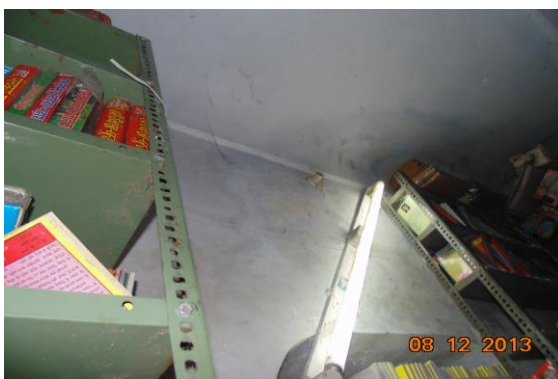
Photo 249

Dampness/Seepage on Wall No. 3 of Shop of Temple of Shri Krishna Chandra Ji Temple, First Floor

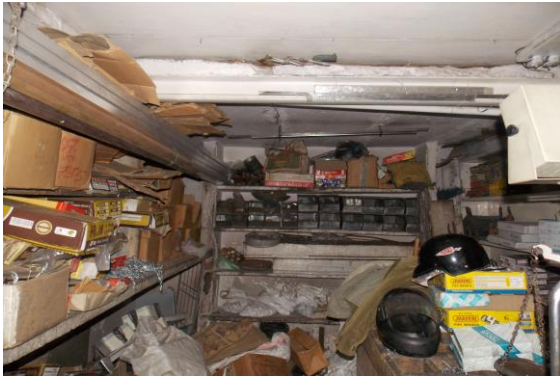
Photo 271

Wall No. 4 of Shop no.342 of Ground Floor Covered With Wooden Racks & Material

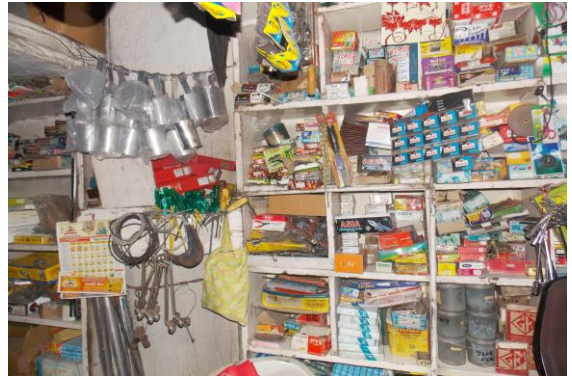
Photo 272

Wall No. 2 of Shop no.342 of Ground Floor Covered With Wooden Racks & Material

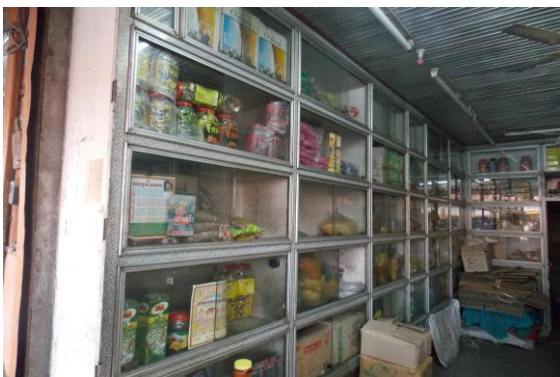
Photo 273

Wall No. 1 of Part A Shop no.341 of Ground Floor Covered With Wooden Racks & Material

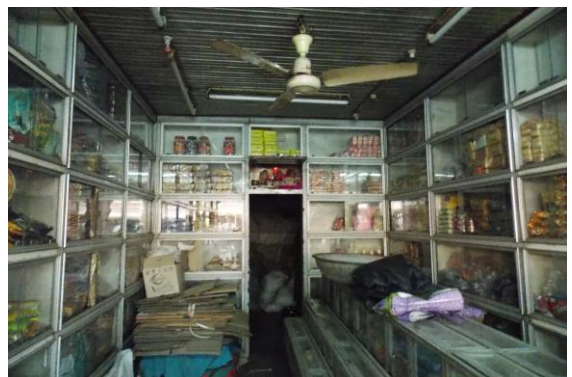
Photo 274

Wall No. 4 of Part A Shop no.341 of Ground Floor Covered With Wooden Racks & Material

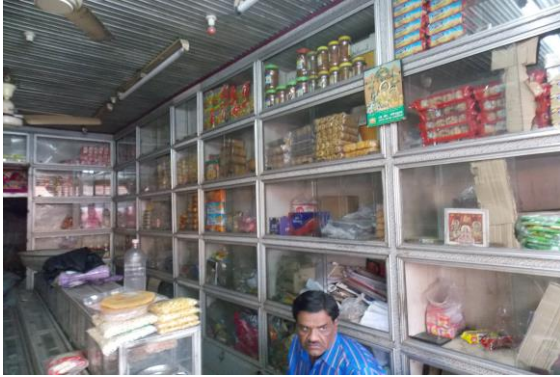
Photo 275

Wall No. 2 of Part A Shop no.341 of Ground Floor Covered With Wooden Racks & Material

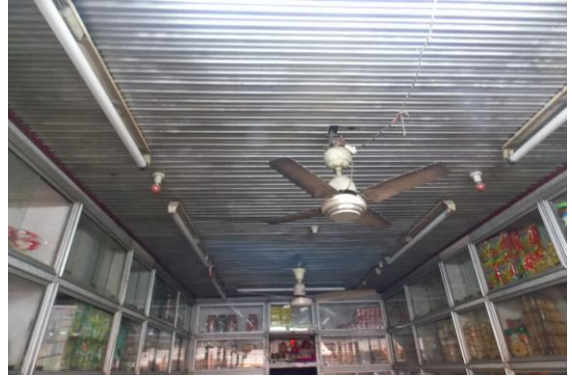
Photo 276

Roof of Part A Shop no.341 of Ground Floor Covered With Wooden Work

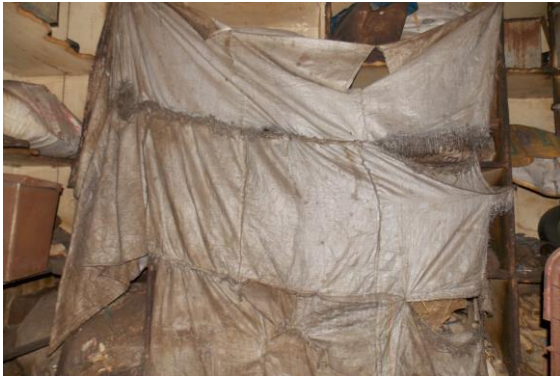
Photo 277

Wall No. 4 of Part B Shop no.341 of Ground Floor Covered With Material

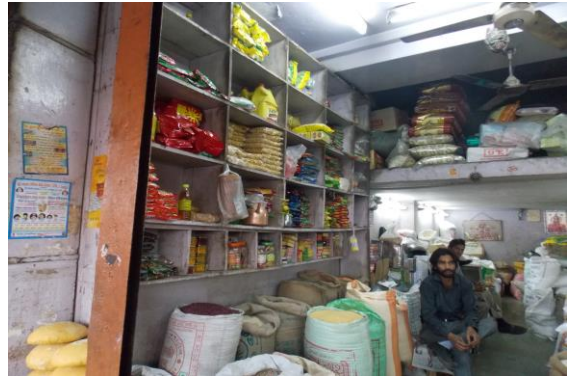
Photo 278

Wall No. 1 of Shop No.340 of Ground Floor Covered With Wooden Racks & Material

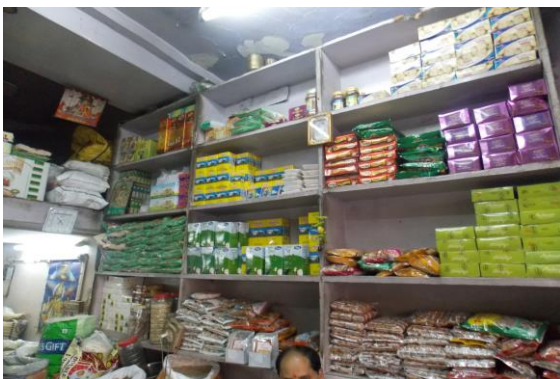
Photo 279

Wall No. 2 of Shop No.340 of Ground Floor Covered With Wooden Racks & Material

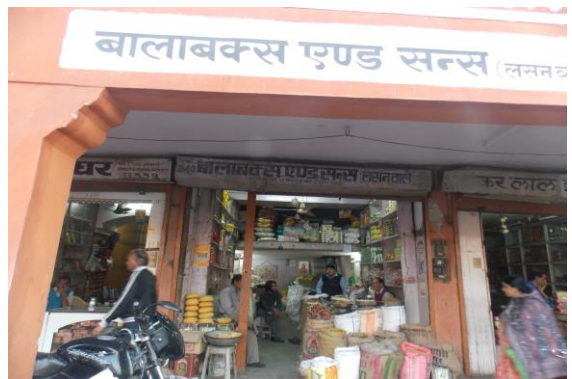
Photo 280

Wall No. 4 of Shop No.340 of Ground Floor Covered With Wooden Racks & Material

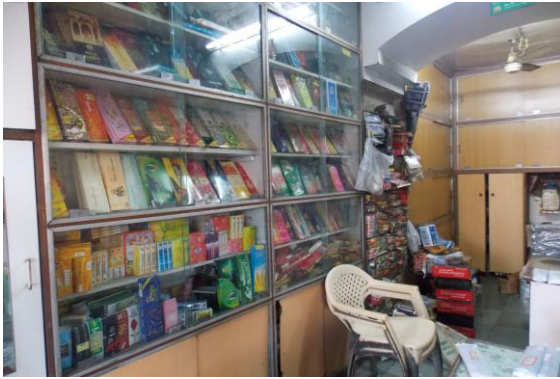
Photo 281

Wall No. 1 of Shop No.339 of Ground Floor Covered With Wooden Racks & Material

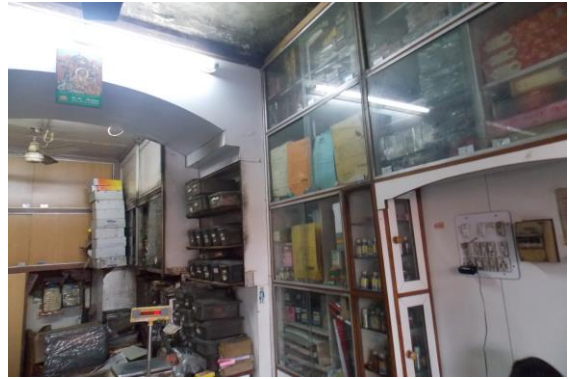
Photo 282

Wall No. 2 of Shop No.339 of Ground Floor Covered With Wooden Racks & Material

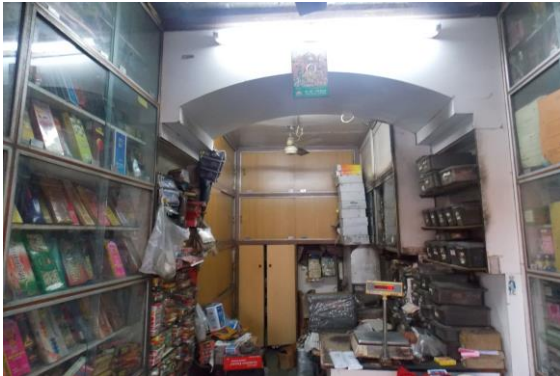
Photo 283

Wall No. 4 of Shop No.339 of Ground Floor Covered With Wooden Racks & Material

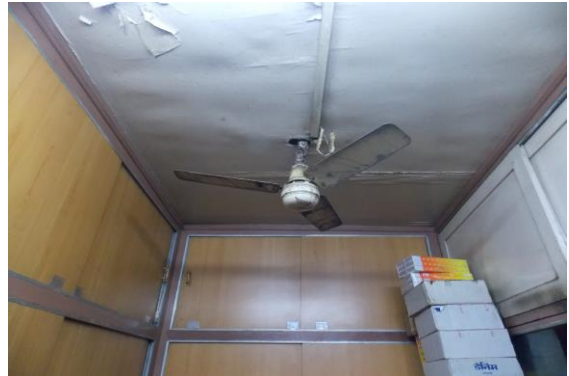
Photo 284

Roof of Shop No.339 of Ground Floor Covered With Wooden Work

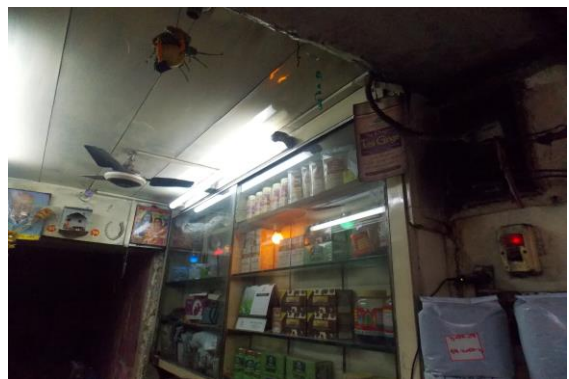
Photo 286

Wall No. 2 of Part A of Shop no.337 of Ground Floor Covered With Wooden Racks & Material

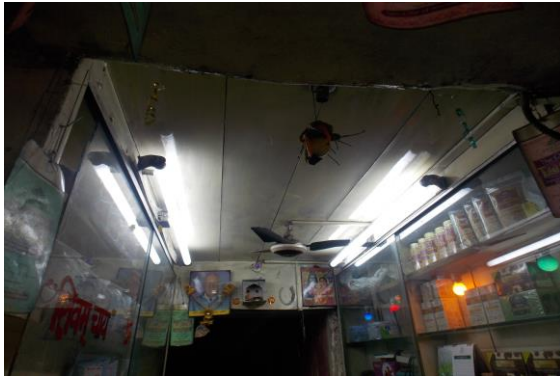
Photo 287

Roof of Part A of Shop no.337 of Ground Floor Covered With Wooden Work

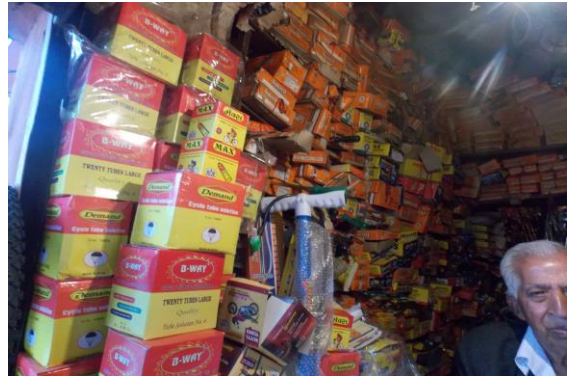
Photo 288

Wall No. 1 of Part A Shop No.336 of Ground Floor Covered With Material

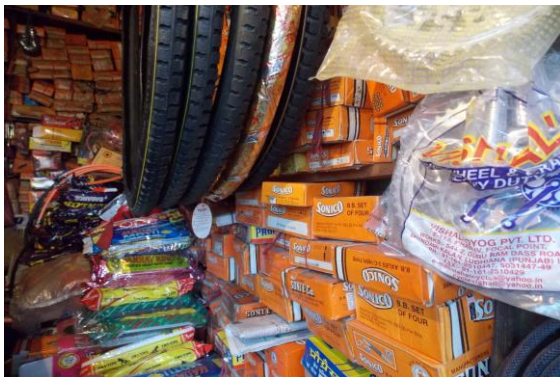
Photo 289

Wall No. 2 of Part A Shop No.336 of Ground Floor Covered With Material

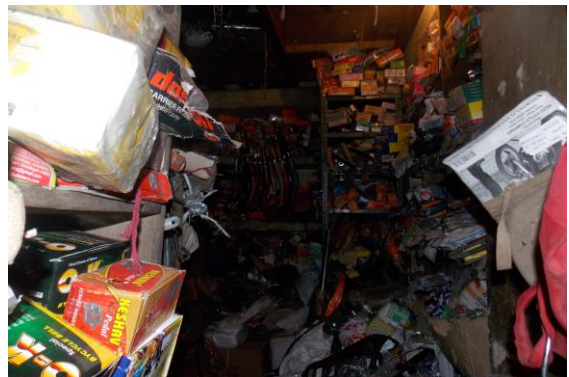
Photo 290

All Walls of Part B Shop No.336 of Ground Floor Covered With Material

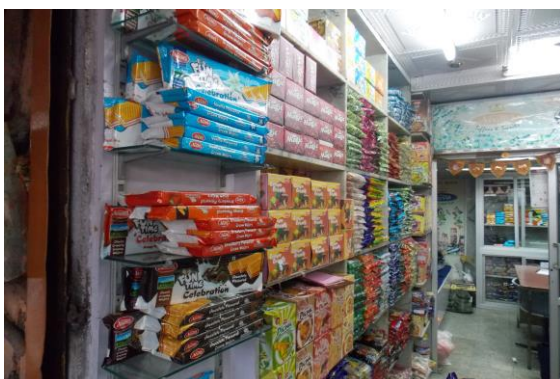
Photo 291

Wall No. 1 of Shop No.338 of Ground Floor Covered With Wooden Racks & Material

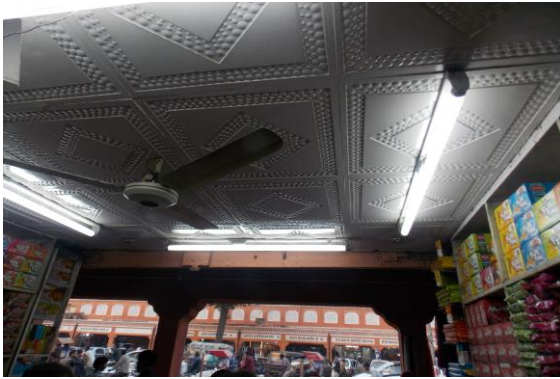
Photo 293

Roof of Shop No.338 of Ground Floor Covered With Wooden Work

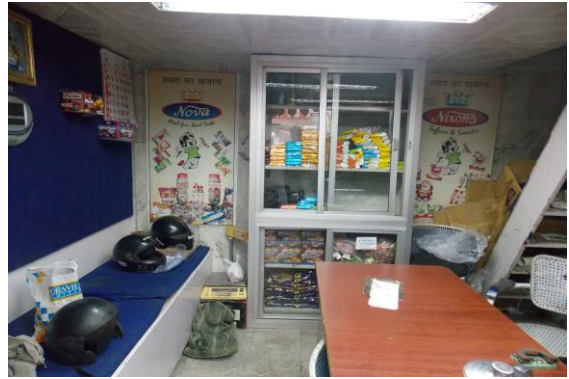
Photo 294

Wall No. 4 of Shop No.338 of Ground Floor Covered With Wooden Racks & Material

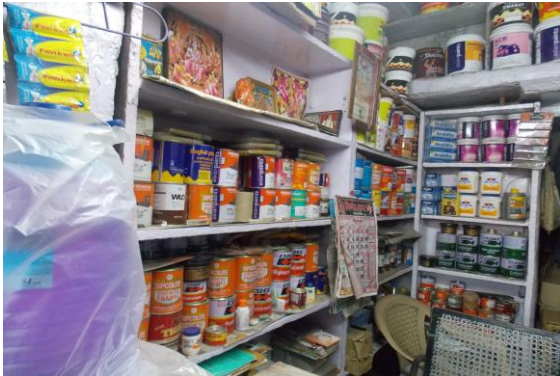
Photo 295

Wall No. 1 of Part A Shop No.344 of Ground Floor Covered With Wooden Racks & Material

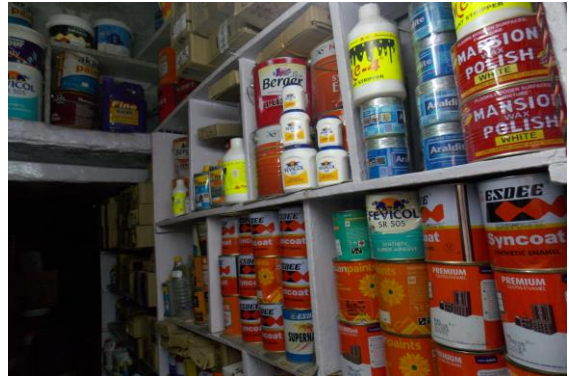
Photo 296

Wall No. 2 of Part A Shop No.344 of Ground Floor Covered With Wooden Racks & Material

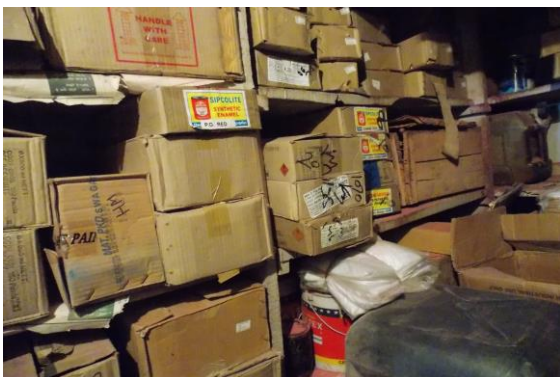
Photo 297

Wall No. 1 of Part B Shop No.344 of Ground Floor Covered With Wooden Racks & Material

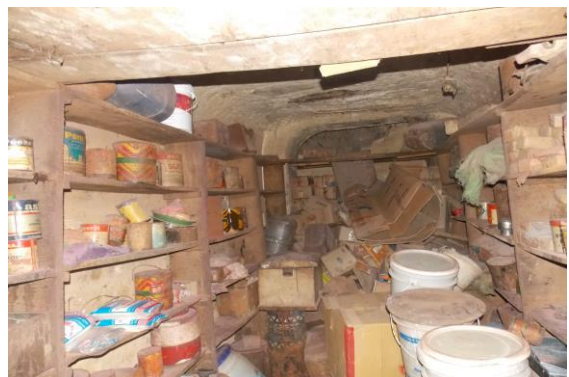
Photo 298

Wall No. 2, 3 & 4 of Part B Shop No.344 of Ground Floor Covered With Wooden Racks & Material

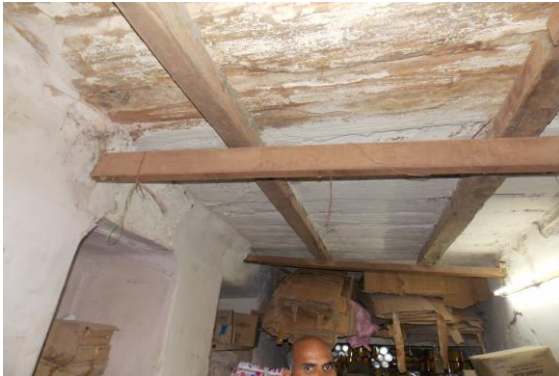
Photo 299

Wall No. 2 of Part C Shop No.344 of Ground Floor Covered With Material

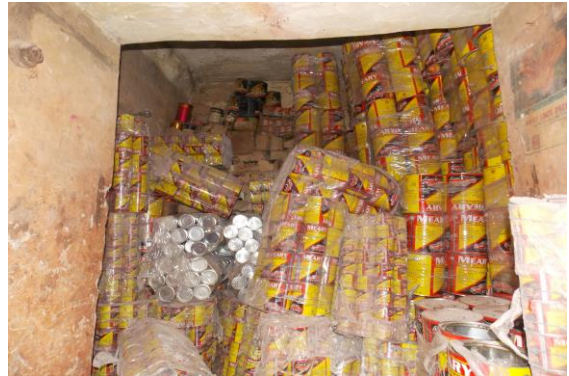
Photo 300

All Walls of Part D Shop No.344 of Ground Floor Covered With Material

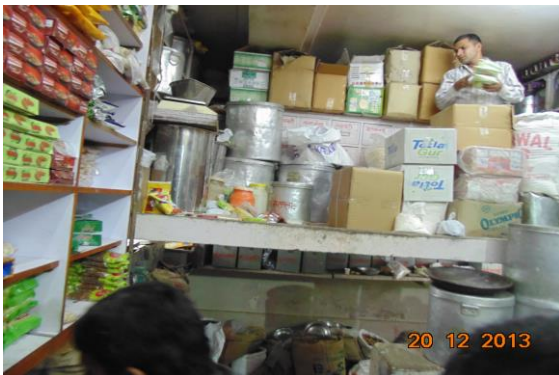
Photo 301

All walls of Shop No.116 of Ground floor

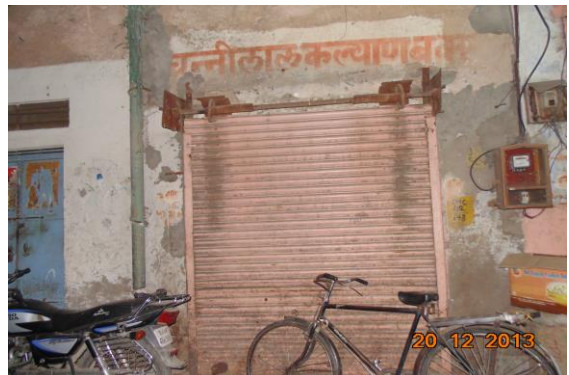
Photo 302

Shop No.115 of Ground floor Locked

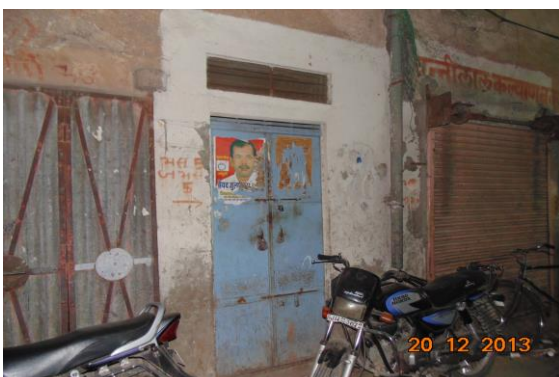
Photo 303

Shop No.114 of Ground floor Locked

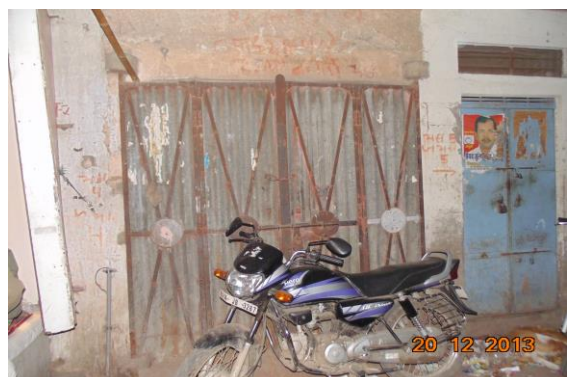
Photo 304

Shop No.113 of Ground floor Locked

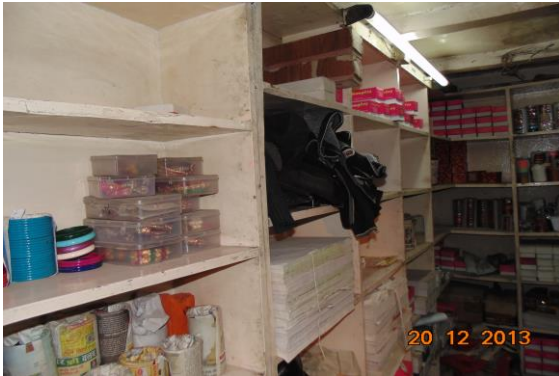
Photo 305

Wall No. 1 of Shop No.112 of Ground floor Covered With Wooden Rack & Material

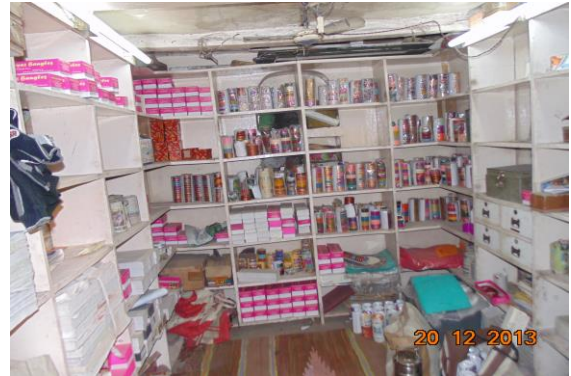
Photo 306

Wall No. 4 of Shop No.112 of Ground floor Covered With Wooden Rack & Material

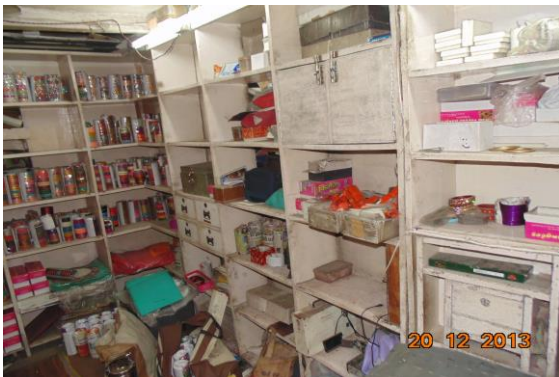
Photo 307

Wall No. 2 of Shop No.112 of Ground floor Covered With Wooden Rack & Material

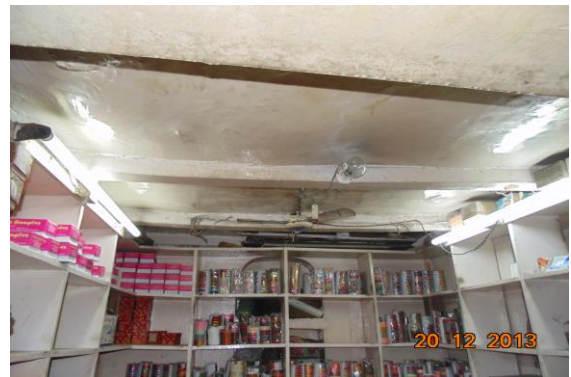
Photo 308

Roof of Shop No.112 of Ground floor Covered With Falls Ceiling

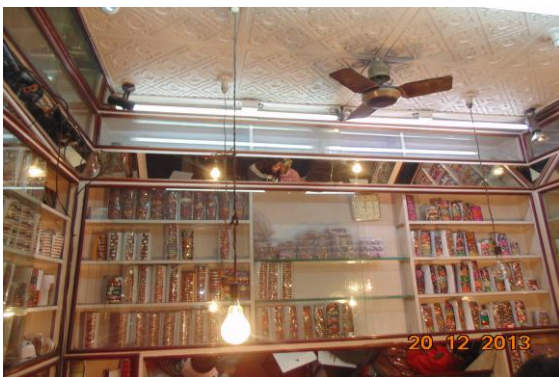
Photo 309

All walls of Shop No.111 of Ground floor Covered With Wooden Rack & Material

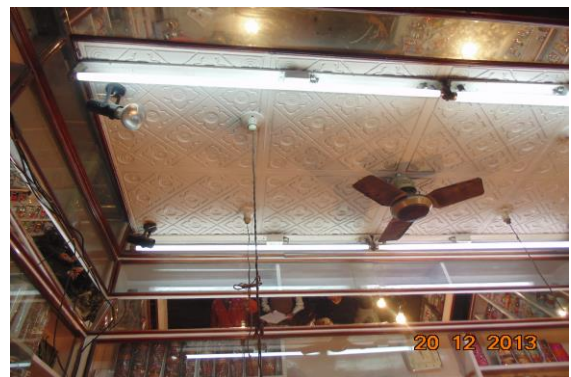
Photo 310

Roof of Shop No.111 of Ground floor Covered With Falls Ceiling

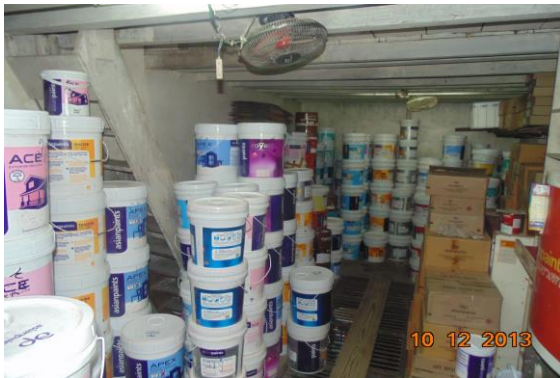
Photo 312

Wall No. 2 & 4 of Shop No.25 of Ground Floor Covered With Material

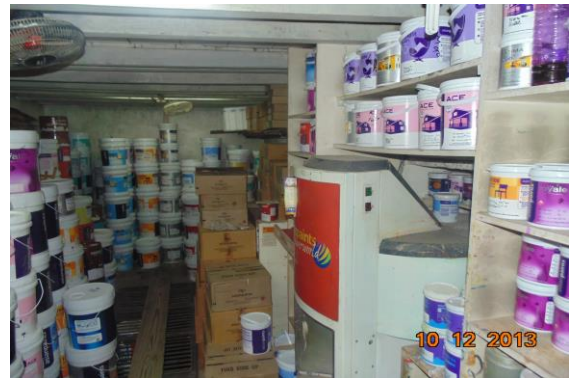
Photo 313

Wall No. 1 & 4 of Shop No.27 of Ground Floor Covered With material

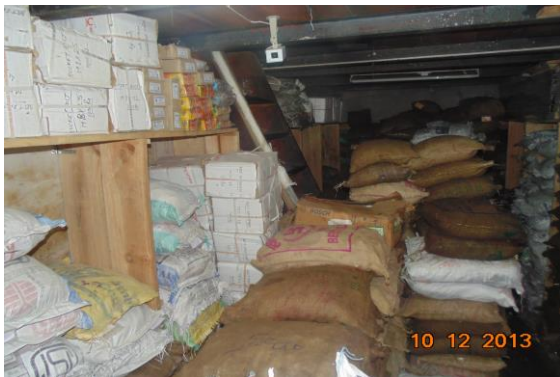
Photo 314

Wall No. 2 & 4 of Shop No.27 of Ground Floor Covered With material

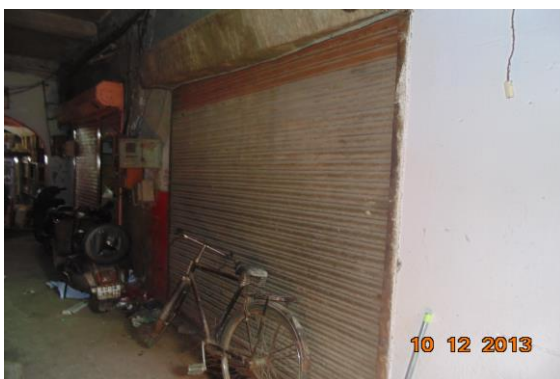
Photo 316

Shop No.28 of Ground Floor Locked

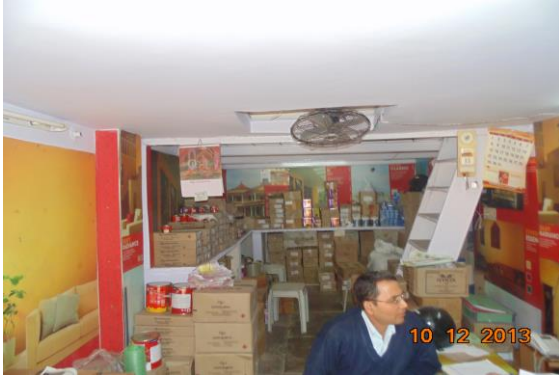
Photo 317

All walls of Shop No.29 of Ground Floor Covered With material

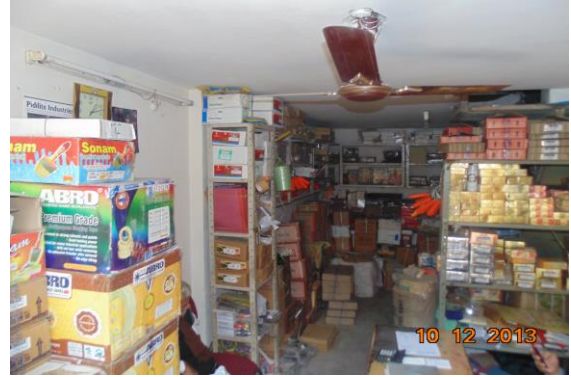
Photo 318

Wall No. 1 & 4 of Shop No.30 of Ground Floor Covered With Material

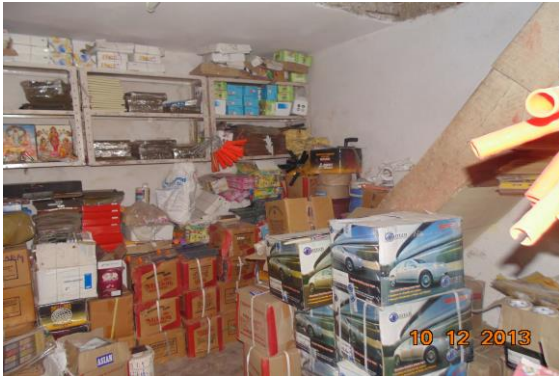
Photo 319

Wall No. 2 & 4 of Shop No.30 of Ground Floor Covered With Material

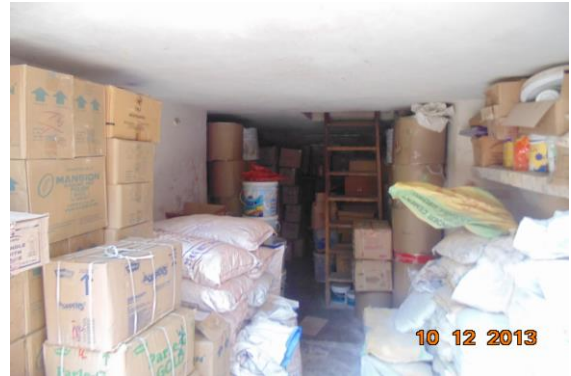
Photo 320

Wall No. 1, 2 & 4 of Shop No.32 of Ground Floor Covered With Material

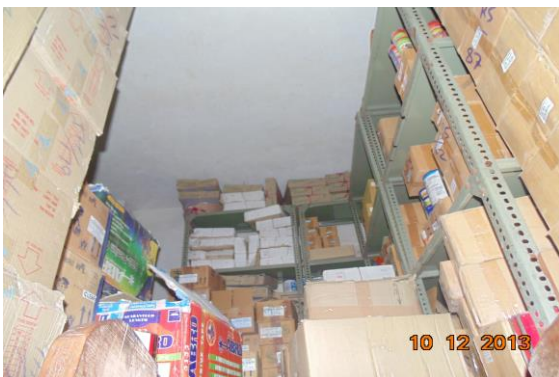
Photo 321

All walls of Shop No.32 of Upper Ground Floor Covered With Material

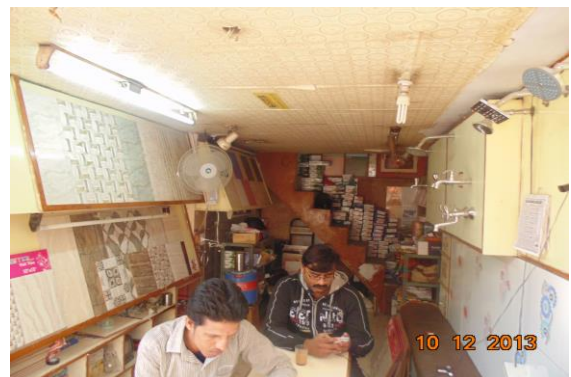
Photo 322

All walls & Roof of Shop No.34 of Ground Floor Covered With Wooden Work &Material

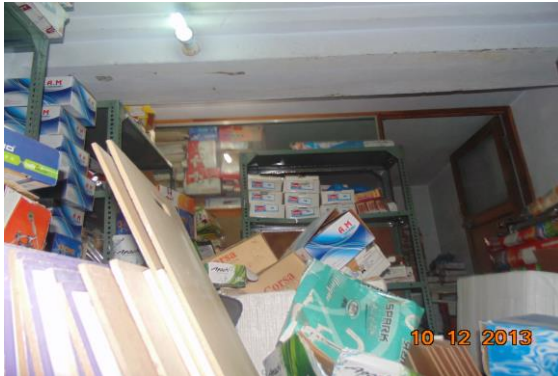
Photo 323

All walls of Shop No.34 of Upper Ground Floor Covered With Wooden Work &Material

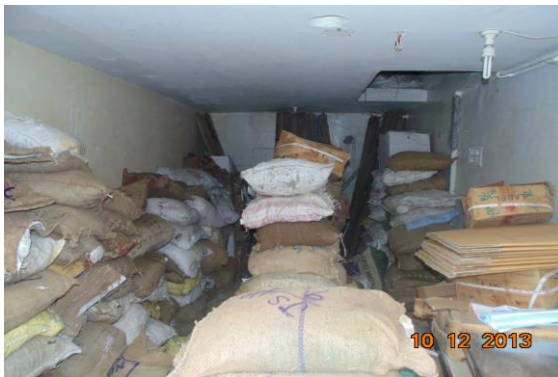
Photo 325

All walls of Shop No.36 of Ground Floor Covered With material

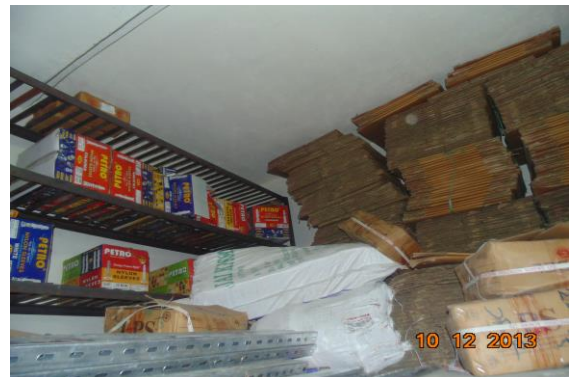
Photo 326

All walls of Shop No.36 of Upper Ground Floor Covered With Material

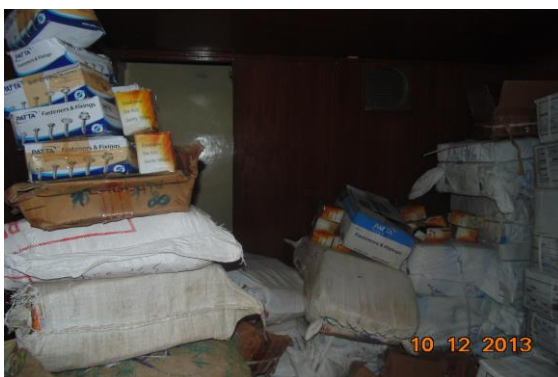
Photo 327

All walls of Shop No.37 of Ground Floor Covered With Wooden Work &Material

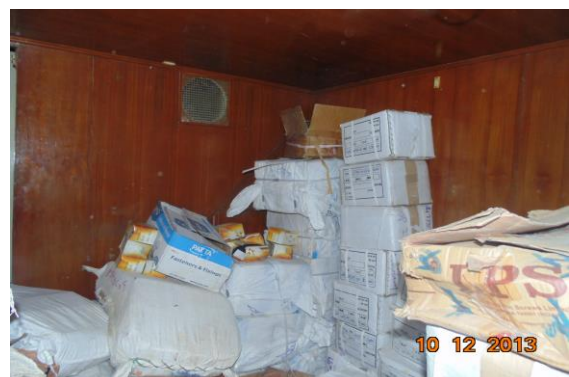
Photo 328

All walls of Shop No.37 of Ground Floor Covered With Wooden Work &Material

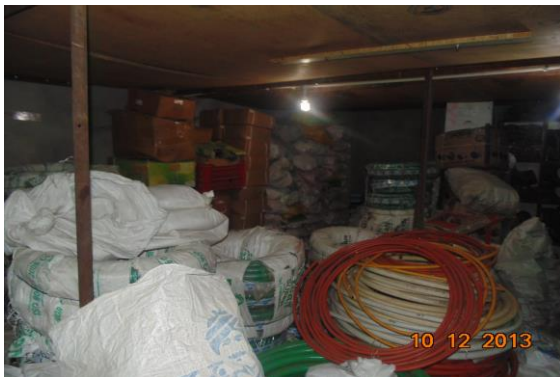
Photo 331
Wall No. 1 & 4 of Shop No. 1 of First Floor Covered With Material

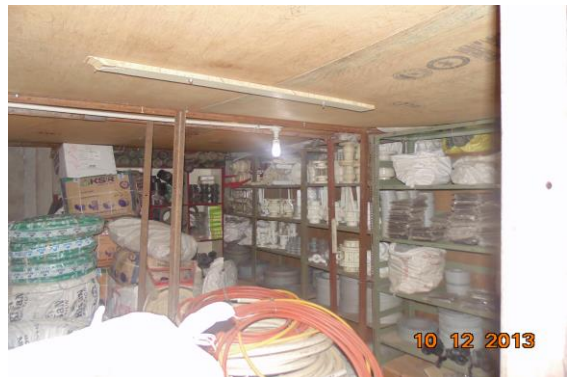
Photo 332
Wall No. 2 & 4 of Shop No. 1 of First Floor Covered With Material

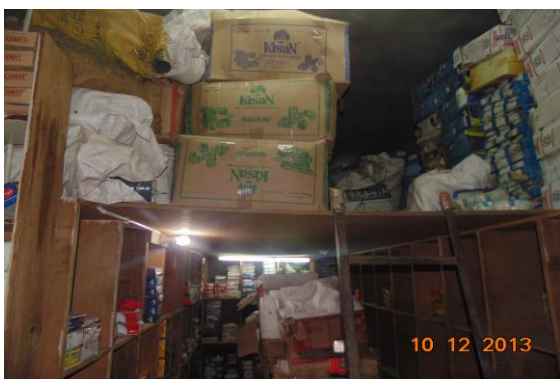
Photo 333
Wall No. 4 of Shop No. 1 of First Floor Covered With Material

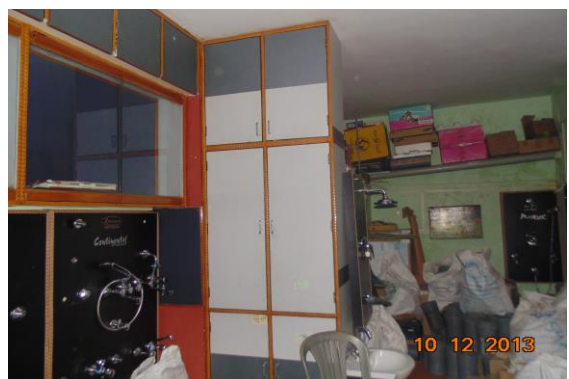
Photo 334
Wall No. 2 & 4 of Shop No. 2 of First Floor Covered with Wooden

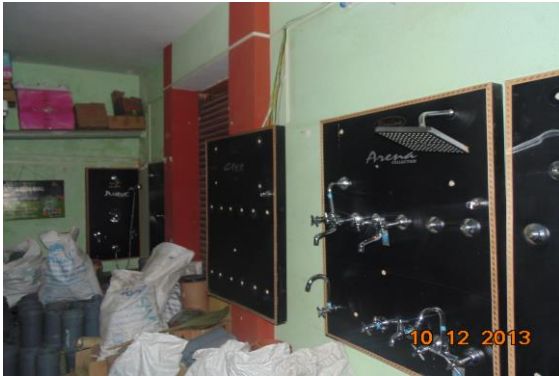
Photo 335

Wall No. 3 of Shop No. 2 of First Floor Covered with Wooden

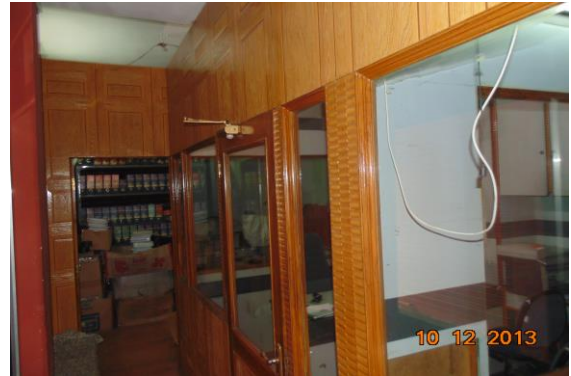
Photo 336

Wall No. 1 of Shop No. 2 of First Floor Covered with Wooden

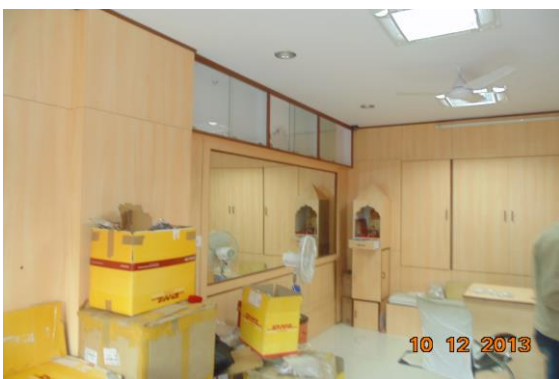
Photo 339

Wall No. 1 & 4 of Shop No.5 & 6 of First Floor Covered with wooden work

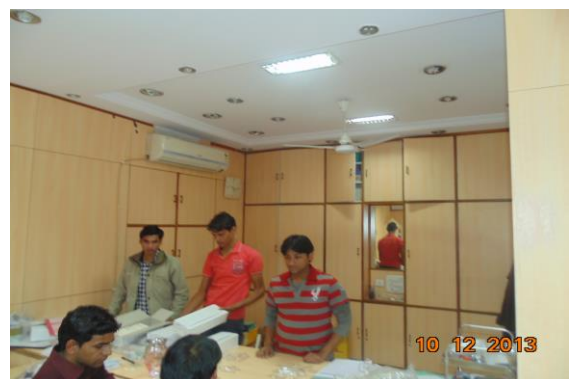
Photo 340

Wall No. 2 & 4 of Shop No.5 & 6 of First Floor Covered with wooden work

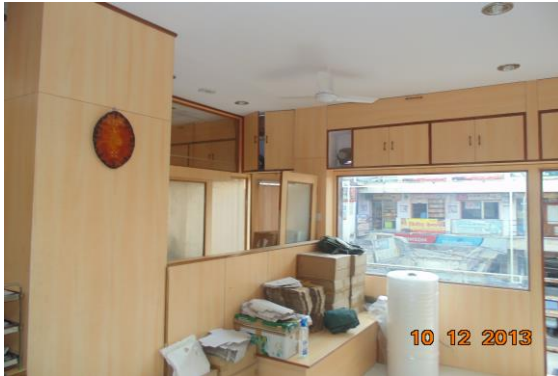
Photo 341

Wall No. 3 of Shop No.5 & 6 of First Floor Covered with wooden work

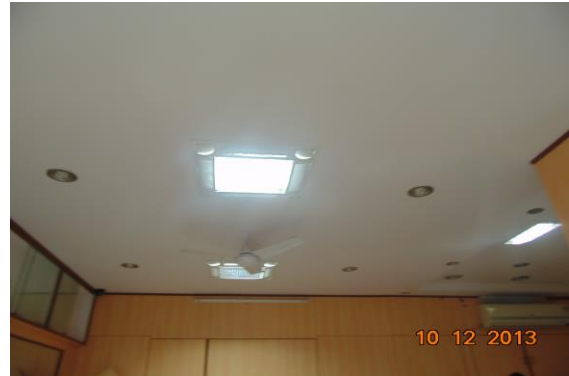
Photo 342

Roof of Shop No.5 & 6 of First Floor Covered with Falls ceiling

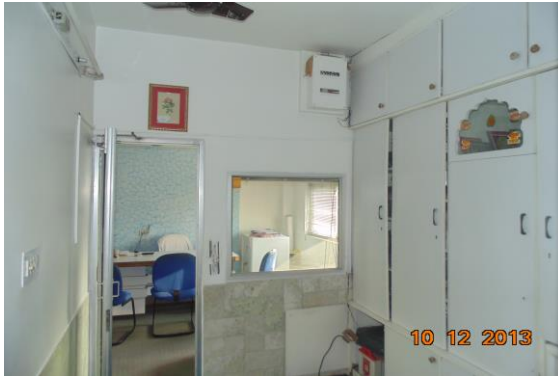
Photo 347

All walls of Shop No.202 of Second Floor Covered With Wooden & Tiles Work

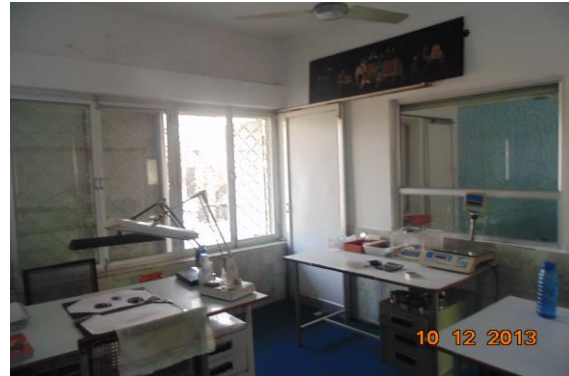
Photo 348

All walls of Shop No.202 of Second Floor Covered With Wooden & Tiles Work

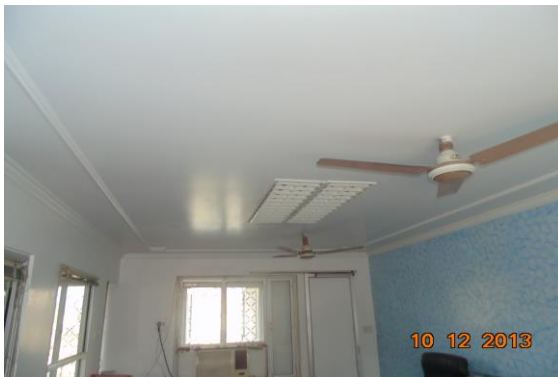
Photo 349

Roof of Shop No.201 to 203 of Second Floor Covered With Falls Ceiling

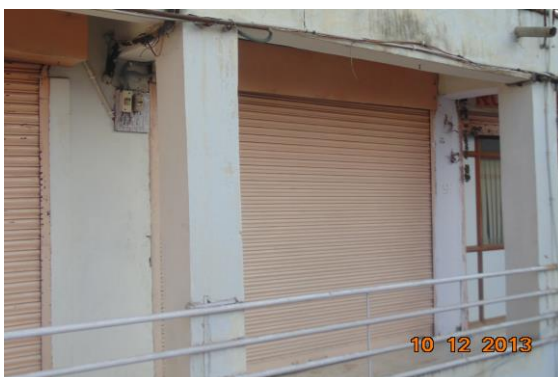
Photo 350

Shop No. 204 of Second Floor Locked

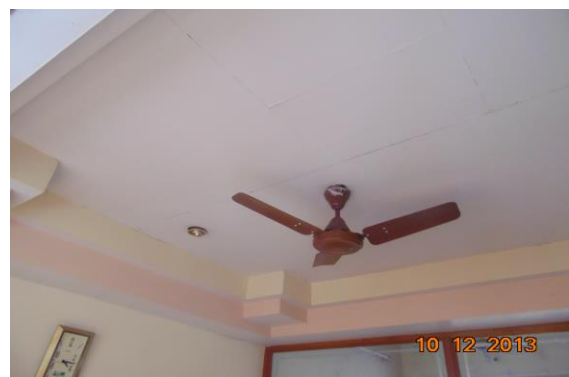
Photo 351

Shop No. 205 of Second Floor Locked

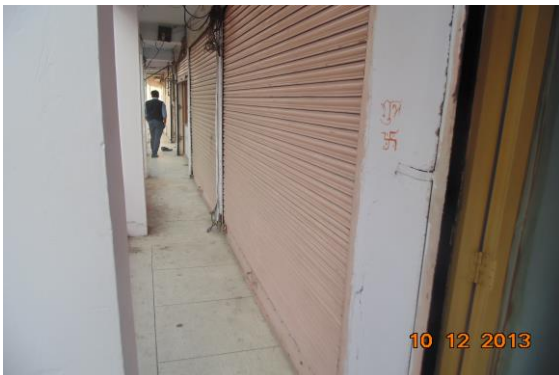
Photo 354

Shop No.208 of Second Floor Locked

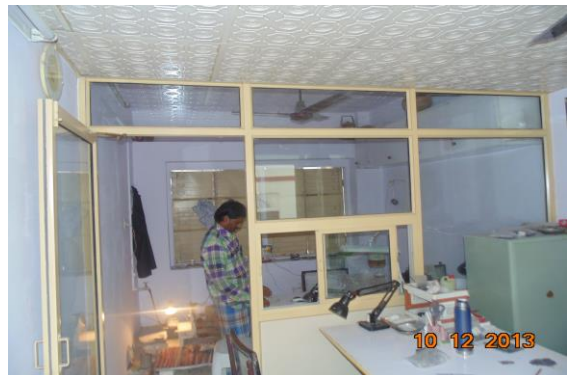
Photo 355

Shop No.209 of Second Floor Locked

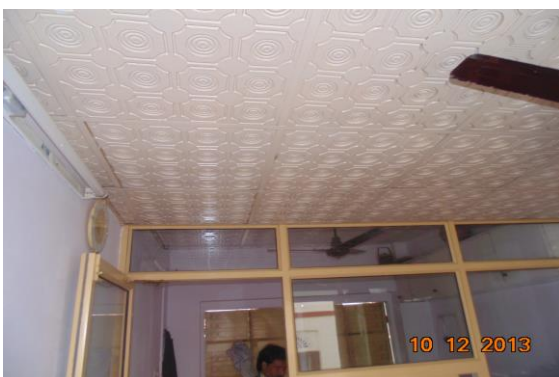
Photo 356

All walls of Shop No.10 of Second Floor Covered with Material

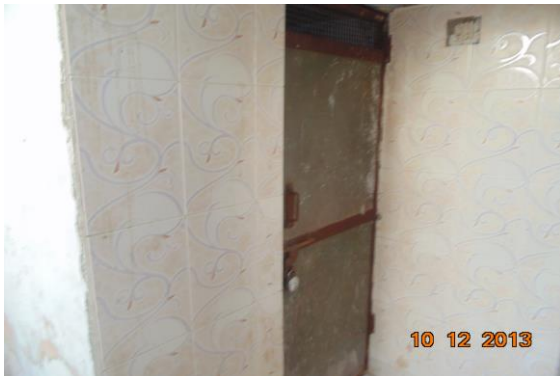
Photo 358

Tin shade Room of Second Floor Locked

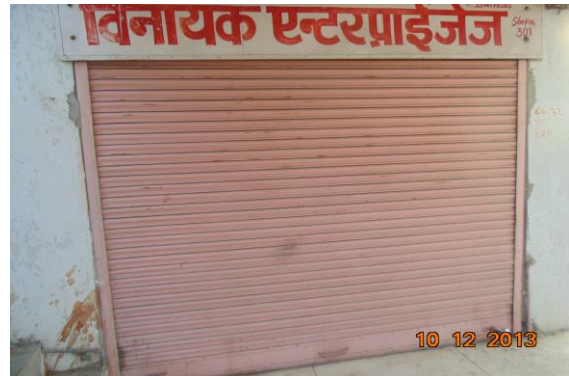
Photo 359
Room No. 1 of Staircase SF to TF Locked

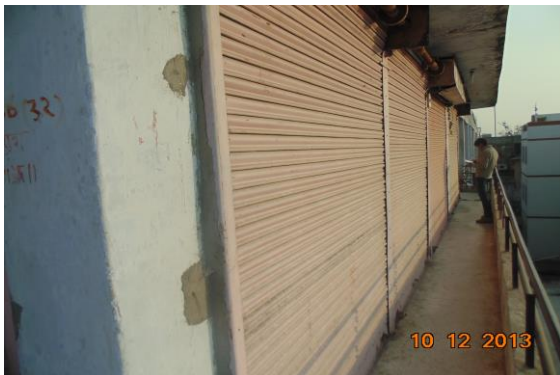
Photo 360
Shop No.301 of Third Floor Locked

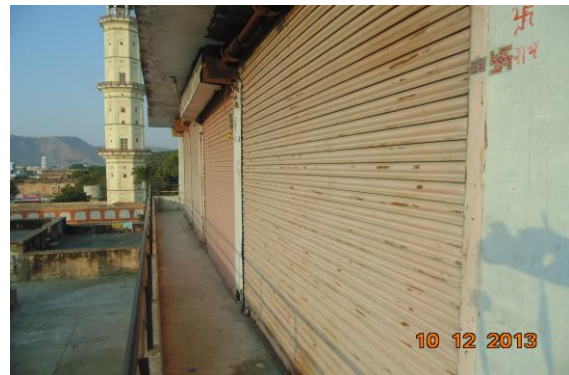
Photo 361
Shop No.302 to 304 of Third Floor Locked

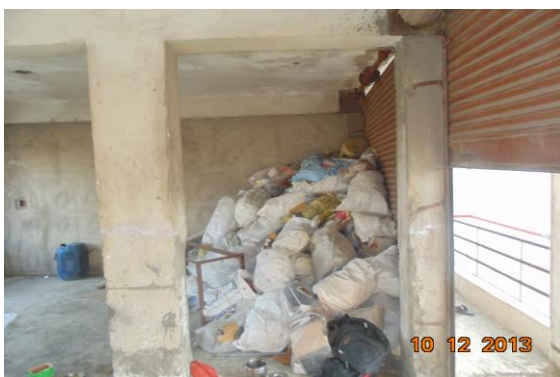
Photo 362
Shop No.302 to 304 of Third Floor Locked

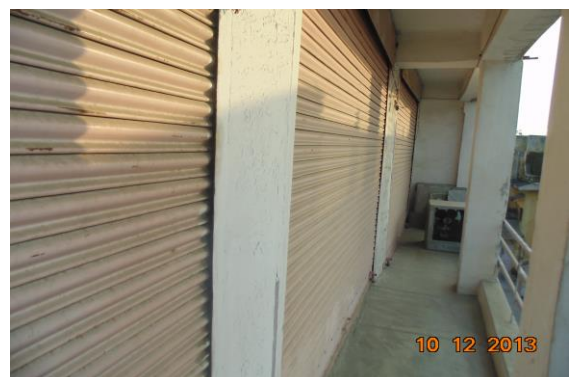
Photo 363
Wall No. 2 of Shop No.305 of Third Floor Covered With material

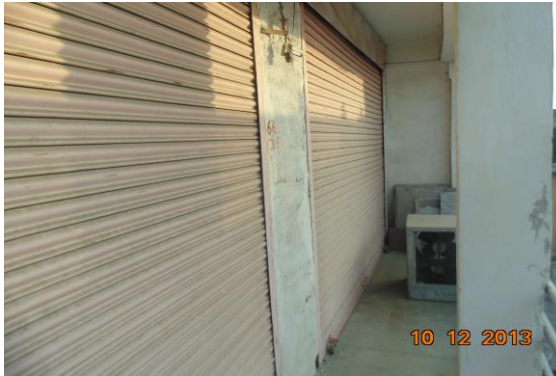
Photo 364
Shop No.309 & 310 of Third Floor Locked

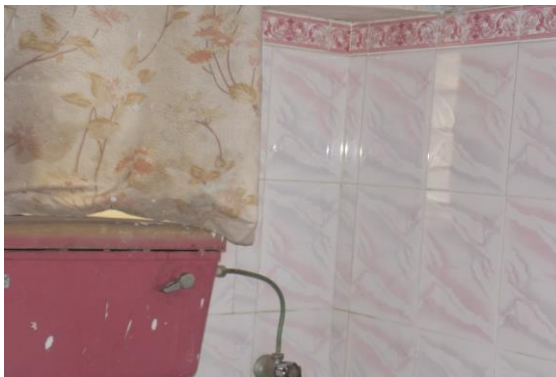
Photo 366
Room No. 4 of Shri Krishna Chandra Ji Temple, First Floor
