Pre Building Condition Survey Report

Name and Address of Structure :	Choti Chopar to Badi Chopar (Down Line)
---------------------------------	---

Name of the Project	Contract JMRC-UG1B “Design and Construction of Tunnel between Chandpole and Badi Chouper and reverse line by Shield TBM, Underground Metro Stations at Choti Chouper and Badi Chouper by Cut and Cover Methods on East West Corridor of Jaipur Metro Rail Corporation Limited .”	
Owner :

Pre Building Condition Survey Report Choti Chopar to Badi Chopar (Down Line)

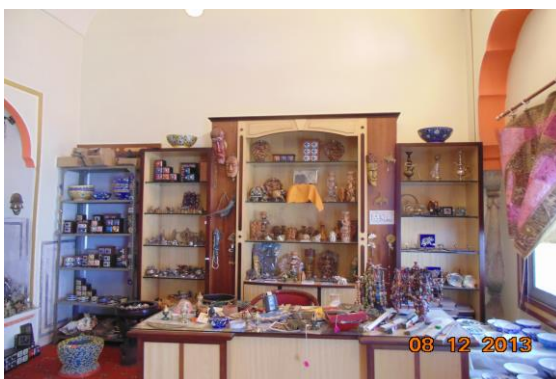
Photo 368
Wall No. 4 of Room No. 7 of Shri Krishna Chandra Ji Temple First Floor
Half Portion Covered with Material

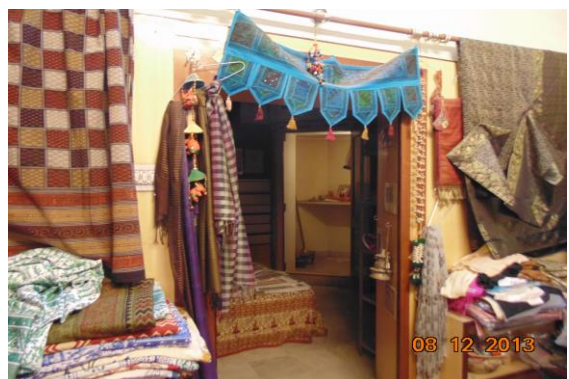
Photo 369
Wall No. 2 of Room No. 7 of Shri Krishna Chandra Ji Temple First Floor
Half Portion Covered with Material

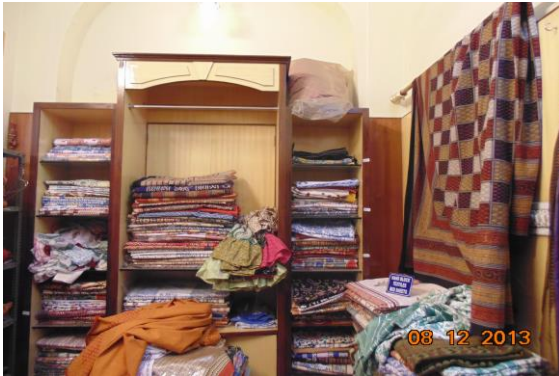
Photo 370
Wall No. 1 of Room No. 7 of Shri Krishna Chandra Ji Temple First Floor
Covered With Material

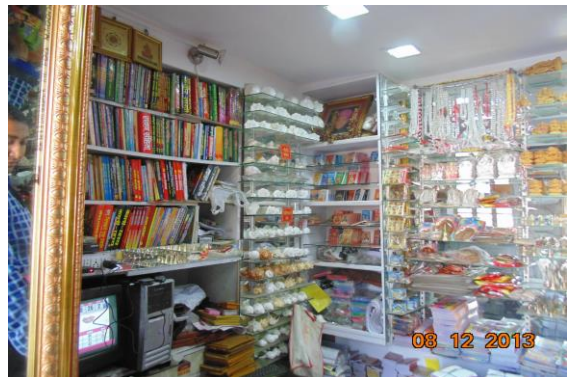
Photo 373

Wall No. 4 of Room No. 15 of Shri Krishna Chandra Ji Temple First Floor Covered With almira

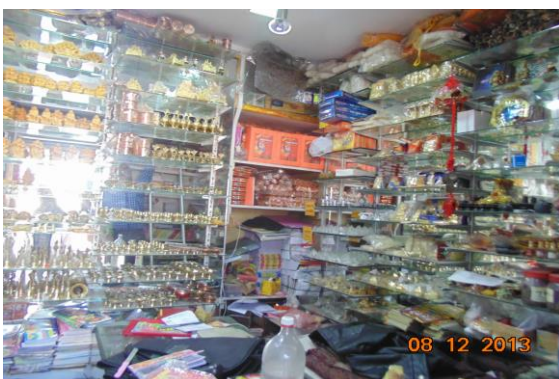
Photo 374

Wall No. 1 & 4 of Shop of Temple of Shri Krishna Chandra Ji Temple, First Floor Covered With material

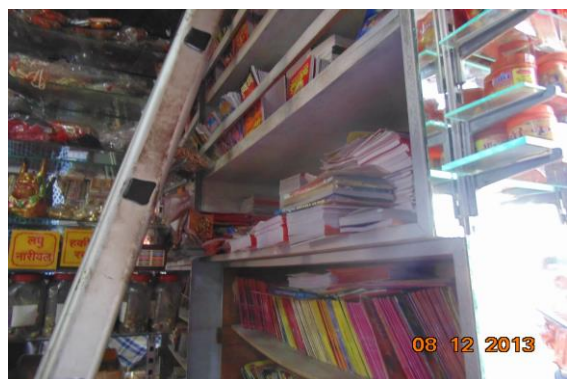
Photo 375

Wall No. 2 & 4 of Shop of Temple of Shri Krishna Chandra Ji Temple, First Floor Covered With material

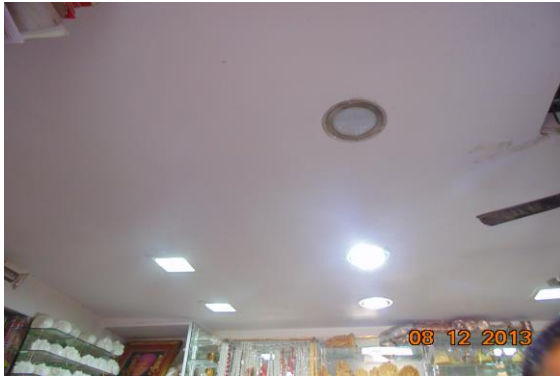
Photo 376

Wall No. 3 of Shop of Temple of Shri Krishna Chandra Ji Temple, First Floor Covered With material

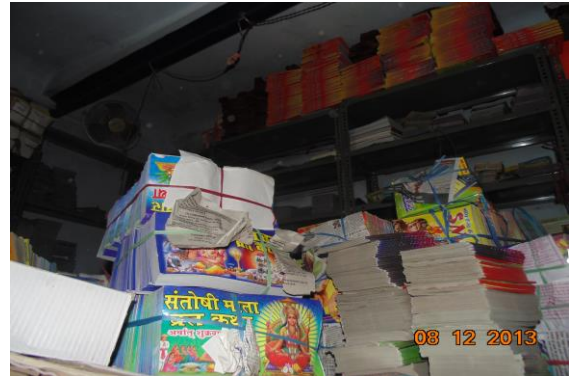
Photo 377

Roof of Shop of Temple of Shri Krishna Chandra Ji Temple, First Floor Covered With Wooden Work

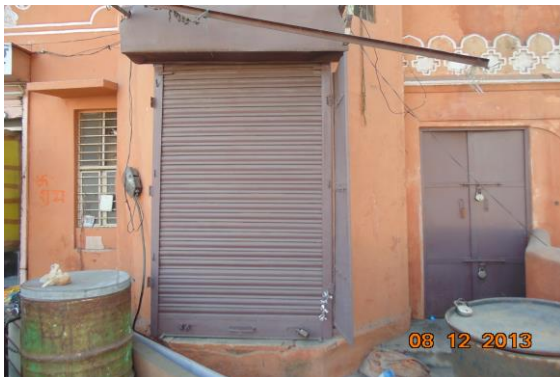
Photo 378

All walls of Shop of Temple of Shri Krishna Chandra Ji Temple, First Floor Covered With material

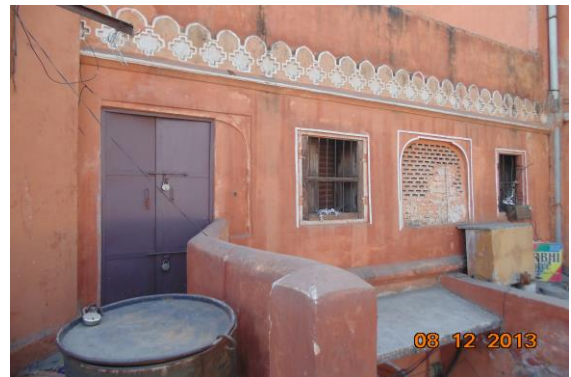
Photo 379

Tomb of Shri Krishna Chandra Ji Temple, First Floor Locked

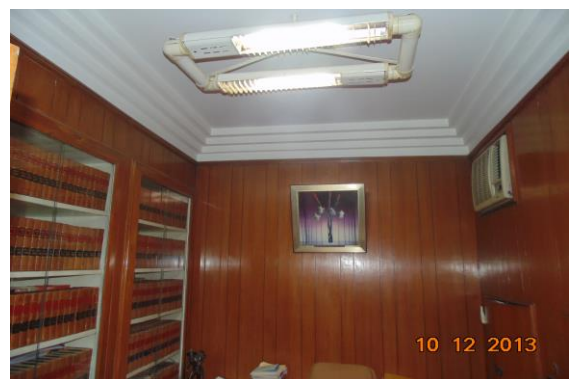
Photo 381

Wall No. 1, 2 & Roof of Part D of Shop No.5 of Ground Floor Covered With Wooden Racks & Falls Ceiling

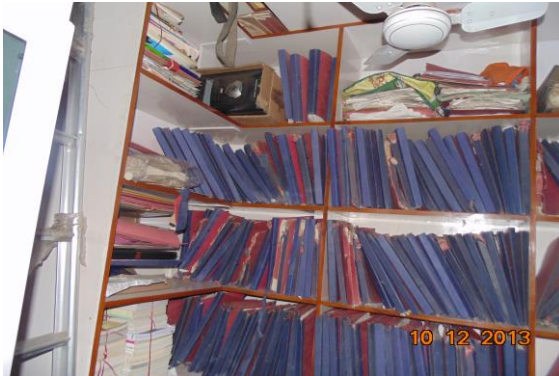
Photo 382

All walls of Part B of Shop No.5 of Ground Floor Covered With Wooden Racks & Falls Ceiling

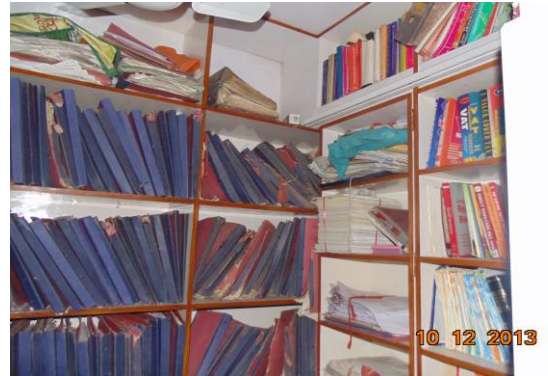
Photo 383

Wall No. 1 & 4 of Part E of Shop No.5 of Ground Floor Covered With Wooden Racks

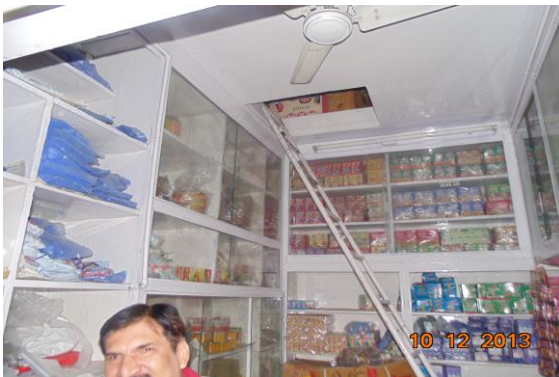
Photo 384

Wall No. 2 & 4 of Part E of Shop No.5 of Ground Floor Covered With Wooden Racks

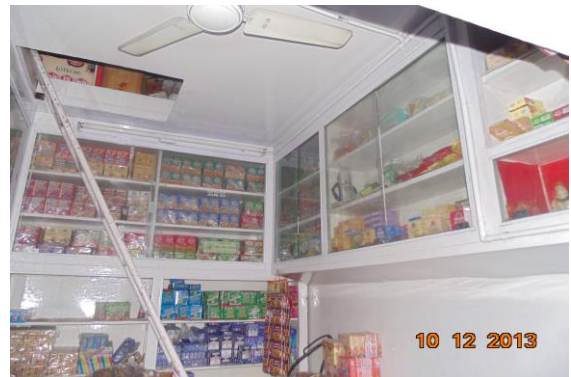
Photo 385

Wall No. 1, 4 & Roof of Shop no.9 of Ground Floor Covered With Wooden Racks

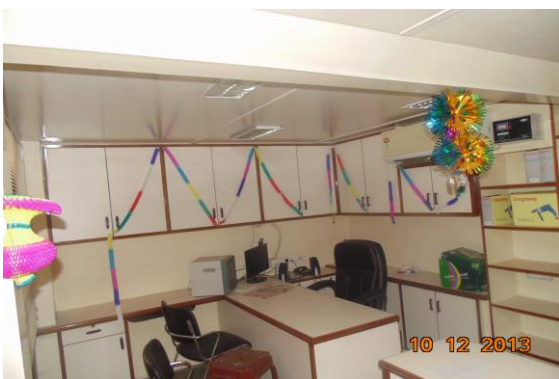
Photo 386

Wall No. 2, 4 & Roof of Shop no.9 of Ground Floor Covered With Wooden Racks

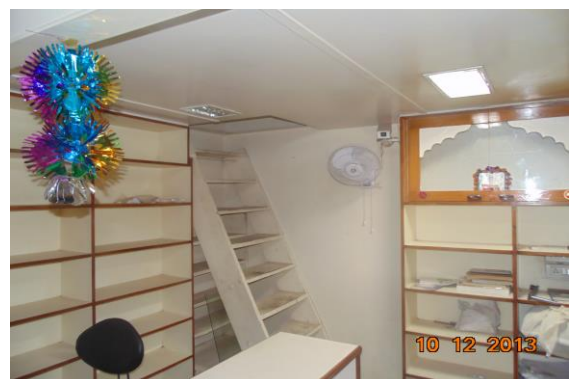
Photo 387

Wall No. 1, 4 & Roof of Shop no.15 of Ground Floor Covered With Wooden Racks

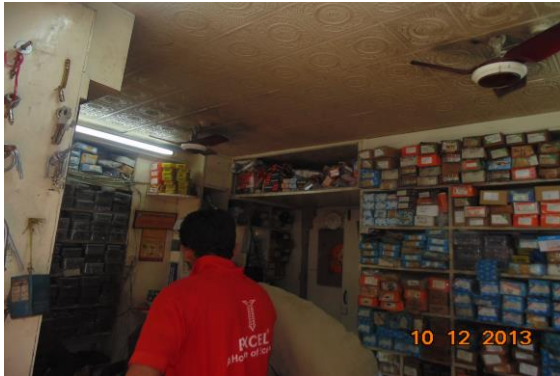
Photo 388

Wall No. 2, 4 & Roof of Shop no.15 of Ground Floor Covered With Wooden Racks

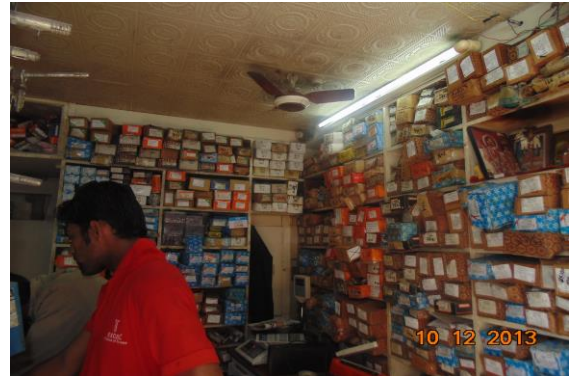
Photo 389

Wall No. 1, 4 & Roof of Shop No.16 of Ground Floor Covered With Wooden Racks & Material

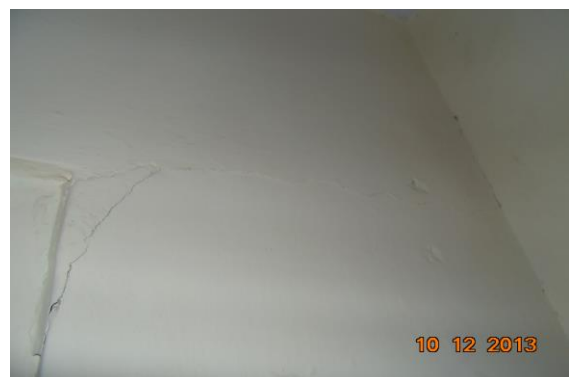
Summary of Cracks						
Defect ID	Location	Orientation	Appx. Width (mm)	Appx. Length (m)	Category	Photo No.
1	Wall No. 3 Room No. 1 Bank of Baroda, First Floor	Horizontal	0.3	0.35	Very Slight	6

Photo 6
Horizontal Crack on Wall No. 3 of Room No. 1, Bank of Baroda, First Floor Approx. Width = 0.3mm, Approx. Length = 0.35m. Distance from Wall No.1 = 0m, Height from Floor = 2m.

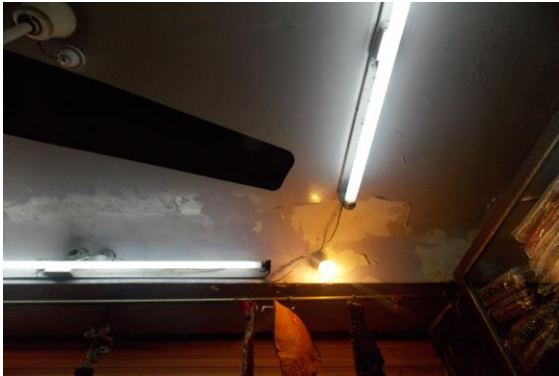
Photo 7
Peeling of Plaster on Roof of Shop No.332 of Ground Floor

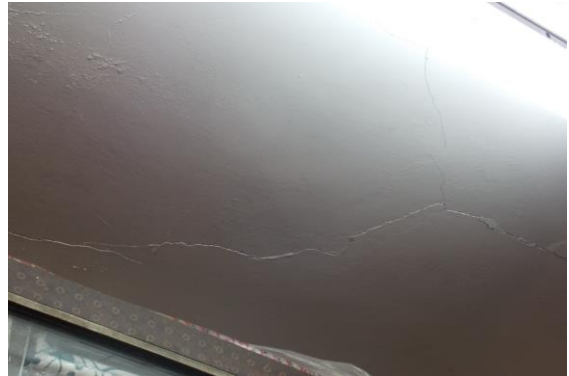
Photo 8
Peeling of Plaster on Roof of Shop No.332 of Ground Floor

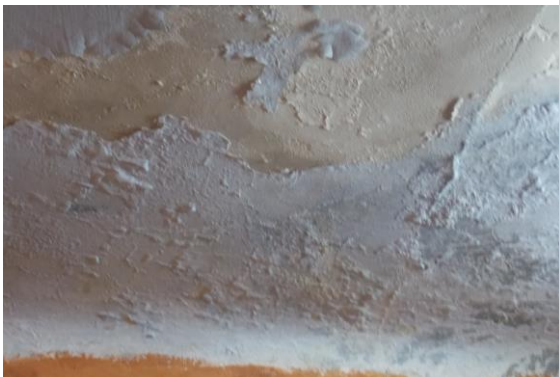
Photo 9
Peeling of Plaster on Roof of Varanda of Shop No.332 of Ground Floor

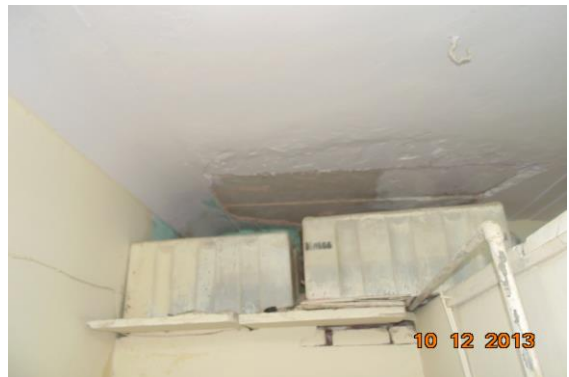
Photo 10
Peeling of Plaster on Roof of Toilet No. 2 of Bank of Baroda, First Floor

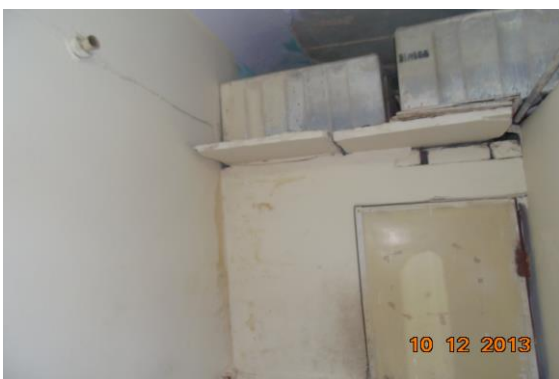
Photo 11
Dampness/Seepage on Wall No. 4 of Toilet No. 2 of Bank of Baroda, First Floor

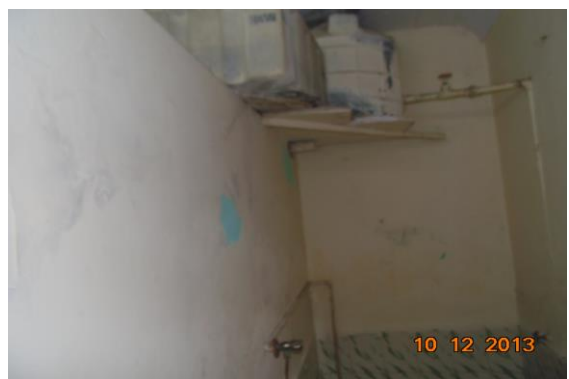
Photo 12
Peeling of Plaster on Wall No. 1 of Toilet No. 1 of Bank of Baroda, First Floor

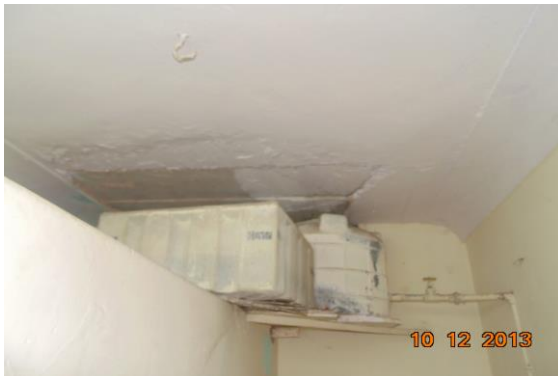
Photo 13

Peeling of Plaster on Roof of Toilet No. 1 of Bank of Baroda, First Floor

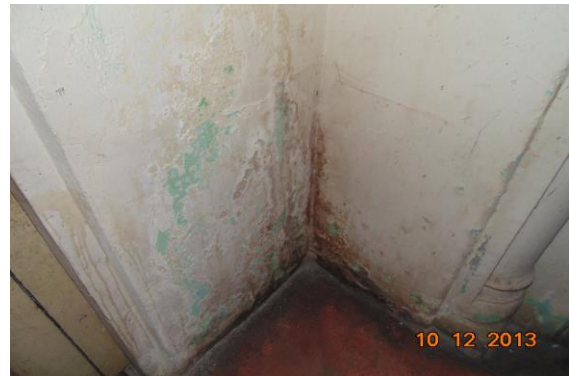
Photo 14

Dampness/Seepage on Wall No. 3 & 2 of Lobby of Bank of Baroda of First Floor

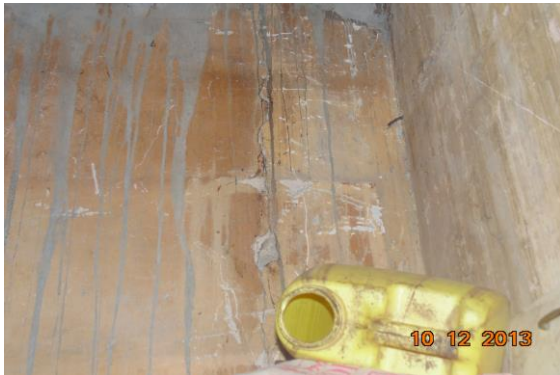
Photo 19

Summary of Cracks						
Defect ID	Location	Orientation	Appx. Width (mm)	Appx. Length (m)	Category	Photo No.
1	Wall No. 1 Shop No.22 Ground Floor	Vertical	3.5	4	Slight	19
2	Roof Shop No.22 Ground Floor	Horizontal	2.5	2	Slight	20

Vertical Crack on Wall No. 1 of Shop No.22, Ground Floor
Approx. Width = 3.5mm, Approx. Length = 4m.
Distance from Wall No.4 = 0.4m, Height from Floor = 0m.

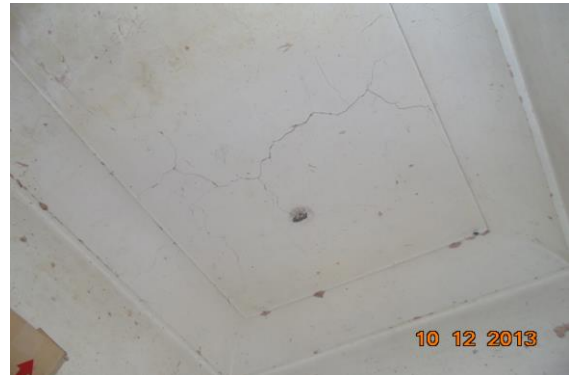
Photo 20

Horizontal Crack on Roof of Shop No.22, Ground Floor
Approx. Width = 2.5mm, Approx. Length = 2m.
Distance from Wall No.4 = 0m, Height from Floor = 4m.

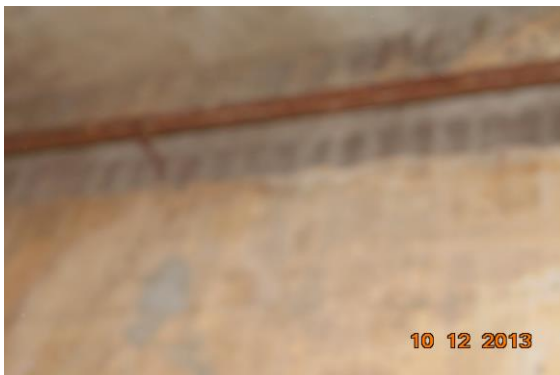
Photo 21

Peeling of Plaster on Wall No. 4 of Shop No.22 of Ground Floor

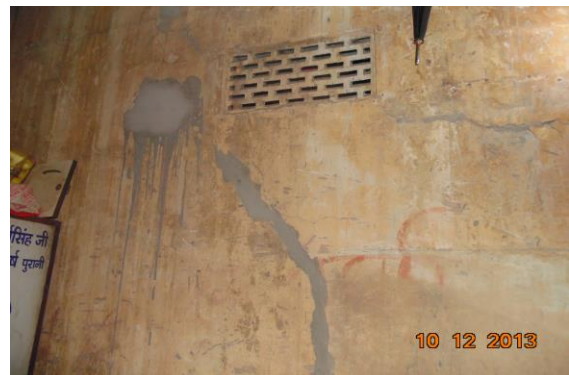
Photo 22

Peeling of Plaster on Wall No. 4 of Shop No.22 of Ground Floor

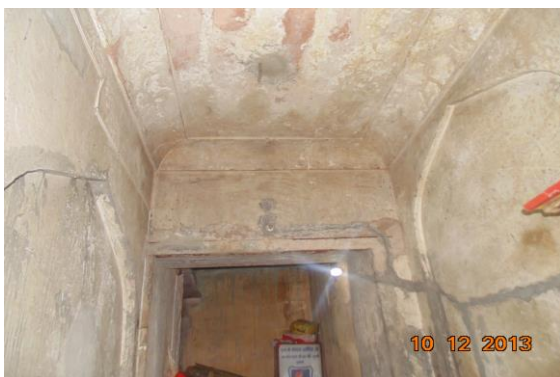
Photo 23

Dampness/Seepage on Wall No. 4, 5 & Roof of Shop No.22 of Ground Floor

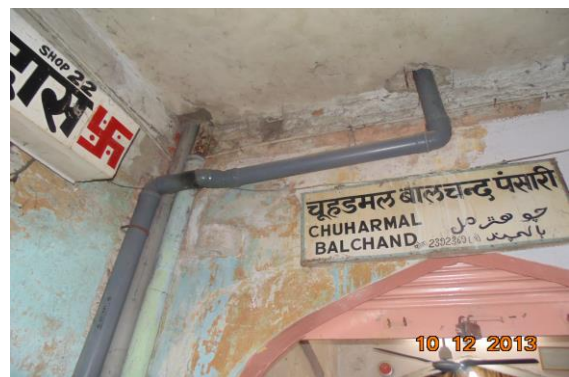
Photo 24

Dampness/Seepage on Outer Wall of Shop No.23 of Ground Floor

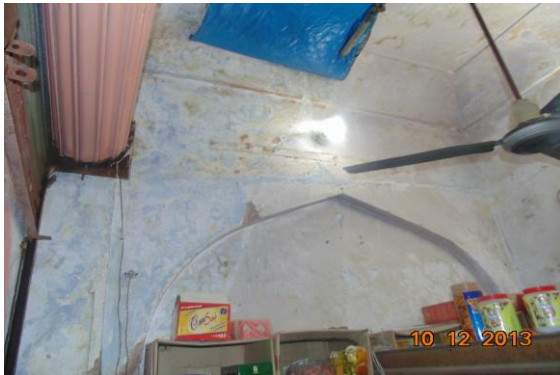
Photo 25

Dampness/Seepage on Wall No. 1 of Shop No.23 of Ground Floor

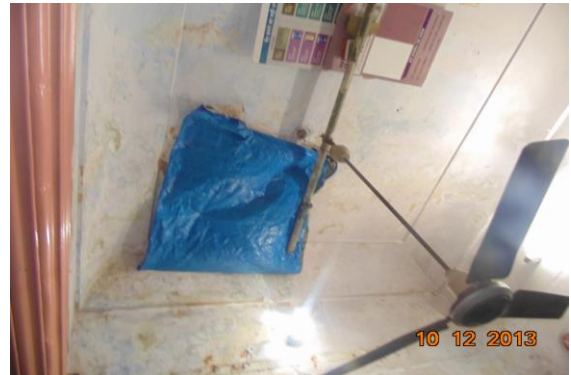
Photo 26

Peeling of Plaster on Wall No. 4 & Roof of Shop No.23 of Ground Floor

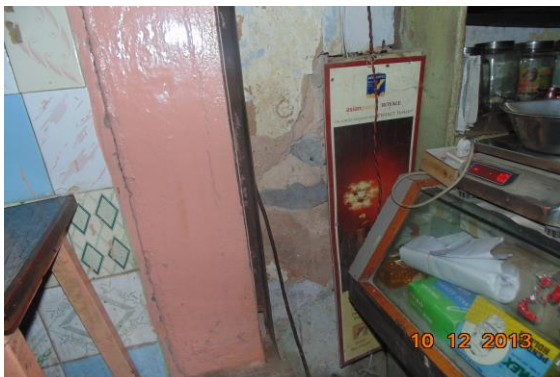
Photo 27

Peeling of Plaster on Wall No. 1 of Shop No.23 of Ground Floor

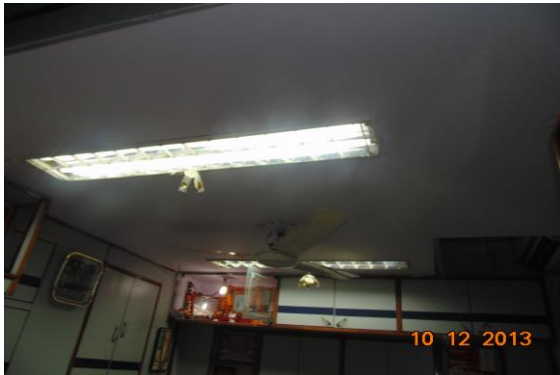
Photo 31

Roof of Shop No. 4 of Ground Floor Covered With Falls Ceiling

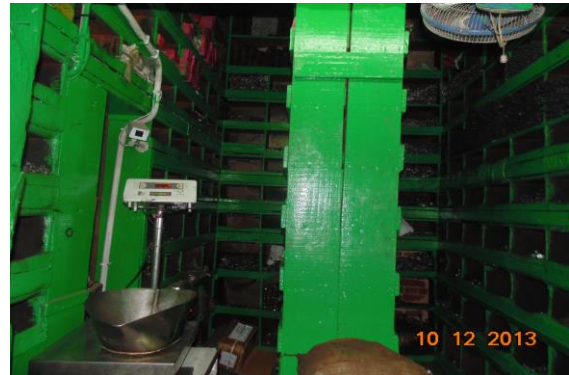
Photo 32

All walls of Shop No. 6 of Ground Floor Covered With Material

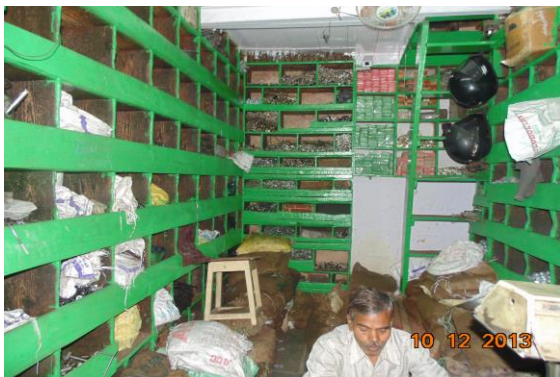
Photo 33

All walls of Shop No. 7 of Ground Floor Covered With Material

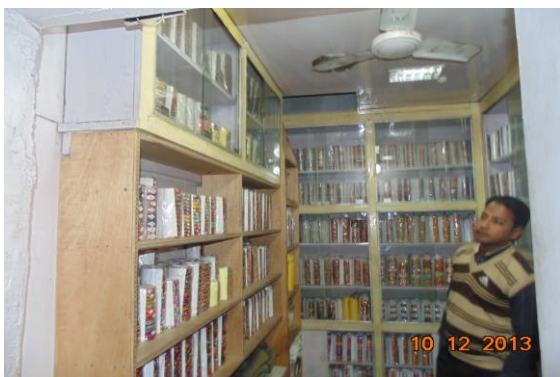
Photo 35

Wall No. 1 & 4 of Shop No. 8 of Ground Floor Covered With Wooden Work & Material

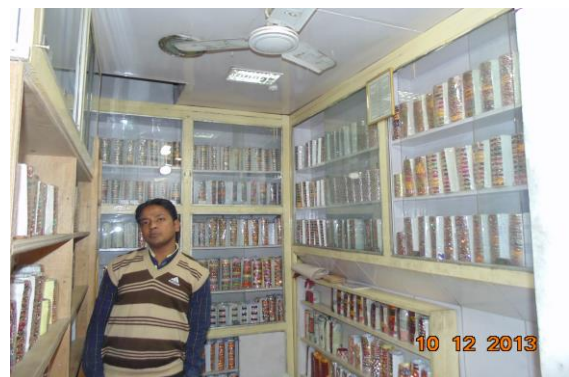
Photo 36

Wall No. 2 & 4 of Shop No. 8 of Ground Floor Covered With Wooden Work & Material

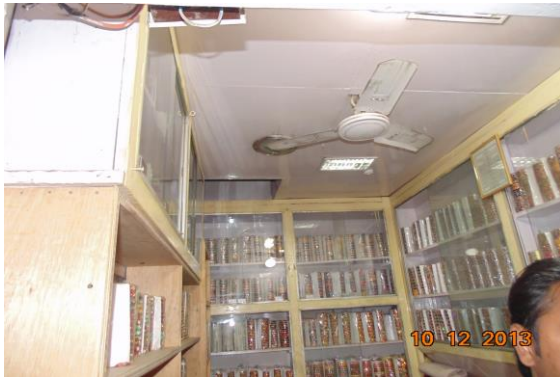
Photo 37

Roof of Shop No. 8 of Ground Floor Covered With Falls Ceiling

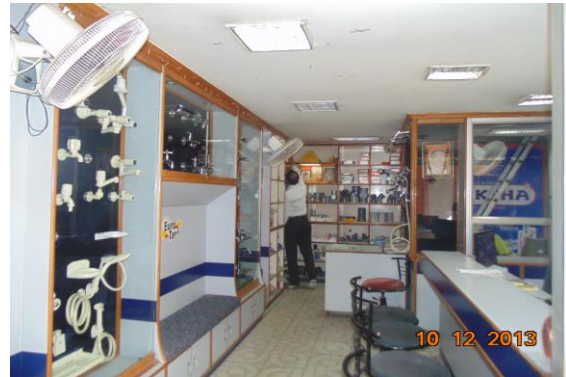
Photo 38

Wall No. 1 & 4 of Shop No. 11 & 14 of Ground Floor Covered With Wooden Work & Material

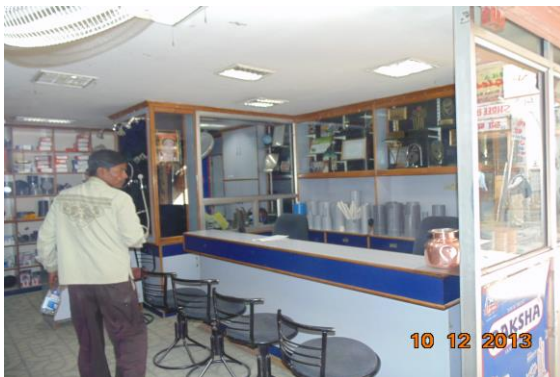
Photo 39

Wall No. 2 & 4 of Shop No. 11 & 14 of Ground Floor Covered With Wooden Work & Material

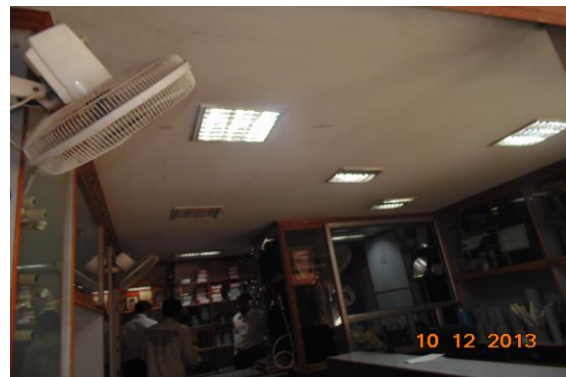
Photo 40

Roof of Shop No. 11 & 14 of Ground Floor Covered With Falls Ceiling

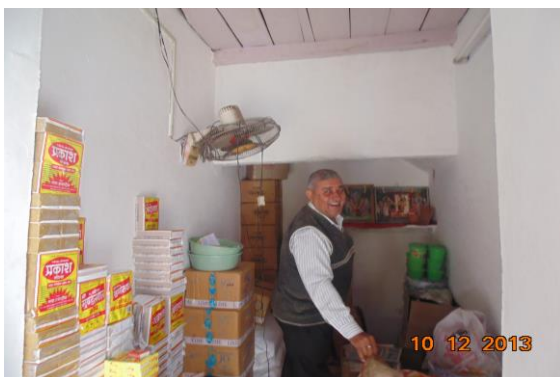
Photo 41

All walls of Shop No. 17 of Ground Floor Covered With Wooden Work & Material

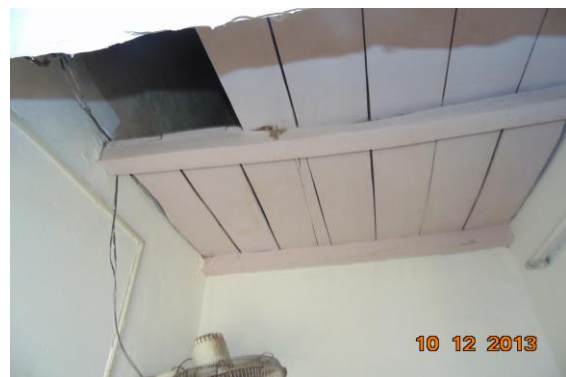
Photo 42

Roof of Shop No. 17 of Ground Floor Covered With Falls Ceiling

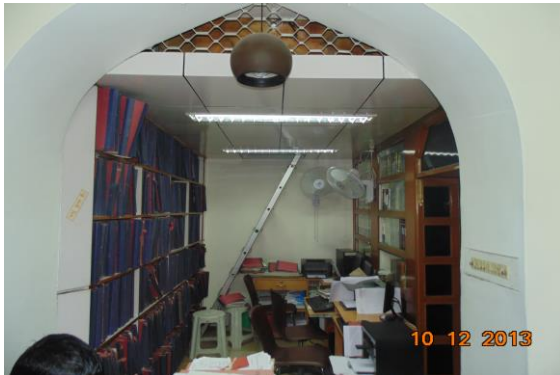
Photo 43

Wall No. 1, 2 & Roof of Part D of Shop No. 5, Ground Floor Covered With Wooden Racks & Falls Ceiling

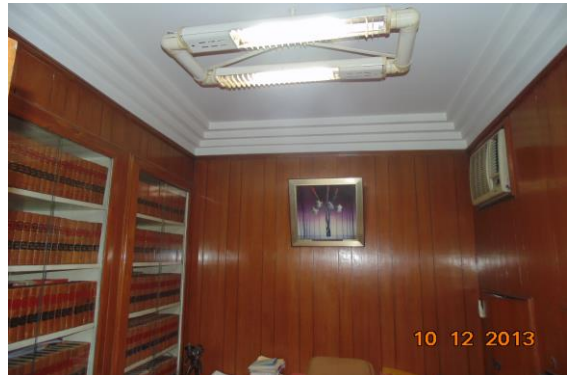
Photo 44

All walls of Part B of Shop No. 5, Ground Floor Covered With Wooden Racks & Falls Ceiling

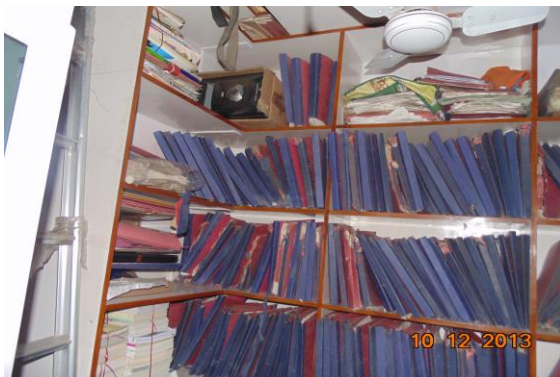
Photo 45

Wall No. 1 & 4 of Part E of Shop No. 5, Ground Floor Covered With Wooden Racks

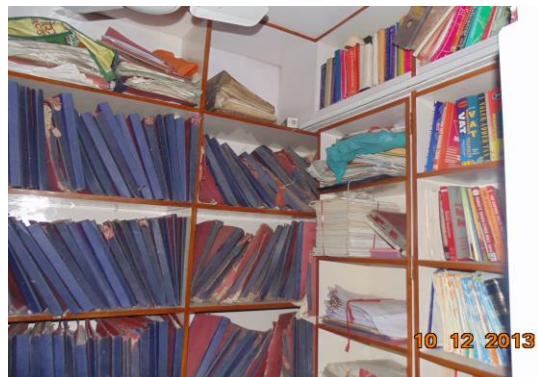
Photo 46

Wall No. 2 & 4 of Part E of Shop No. 5, Ground Floor Covered With Wooden Racks

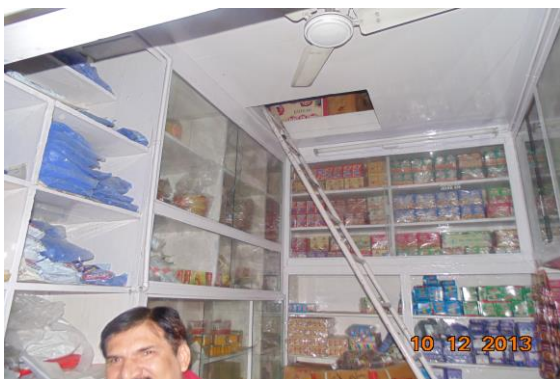
Photo 47

Wall No. 1, 4 & Roof of Shop No. 9 of Ground Floor Covered With Wooden Racks

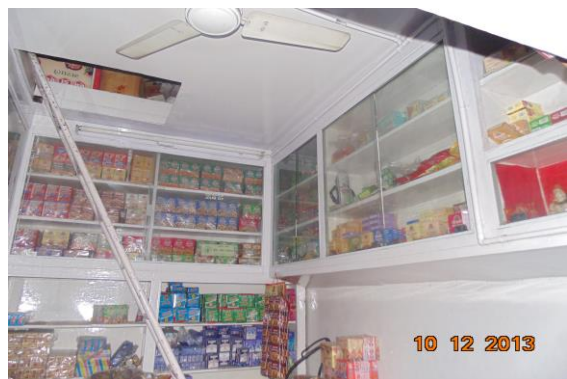
Photo 48

Wall No. 2, 4 & Roof of Shop No. 9 of Ground Floor Covered With Wooden Racks

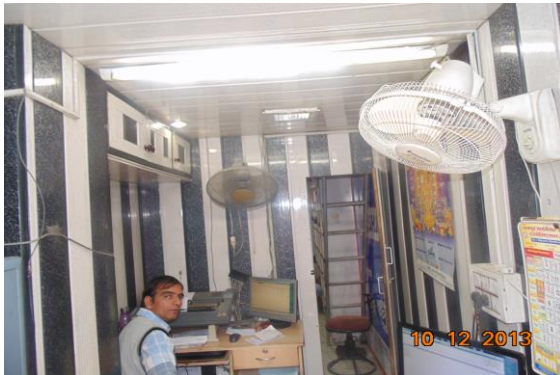
Photo 49

All walls & Roof of Shop No.19 of Ground Floor Covered With Wooden
& Roof Fall Ceiling

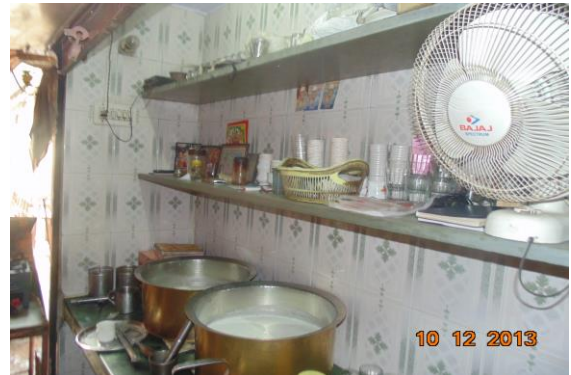
Photo 50

Wall No. 1 & 4 of Shop No.20 of Ground Floor Covered With tiles

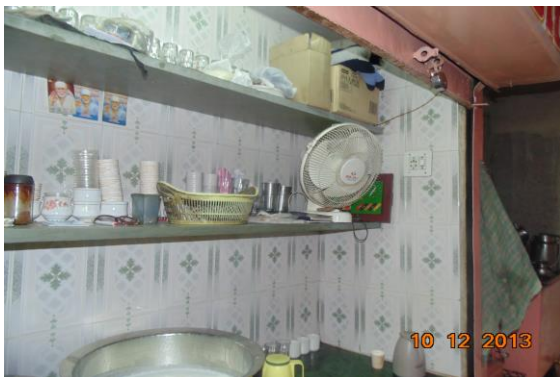
Photo 51

Wall No. 2 & 4 of Shop No.20 of Ground Floor Covered With Tiles

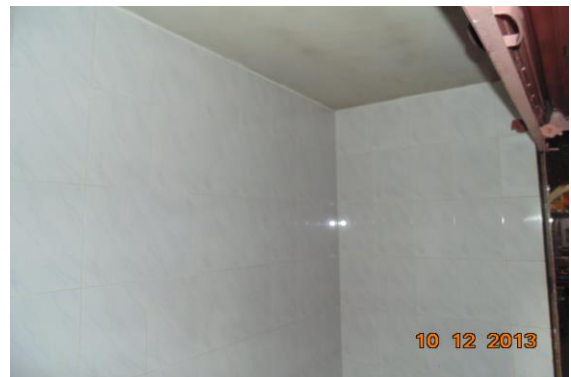
Photo 52

Wall No. 2 & 4 of Shop No.21 of Ground Floor Covered With tiles

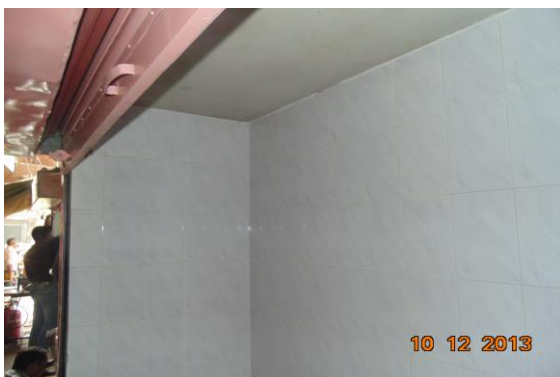
Photo 53

Wall No. 1 & 4 of Shop No.21 of Ground Floor Covered With Tiles

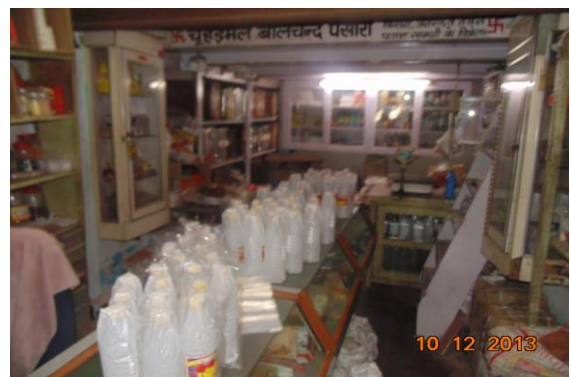
Photo 54

Wall No. 1 & 4 of Shop No.23 of Ground Floor Covered With wooden
Racks & Material

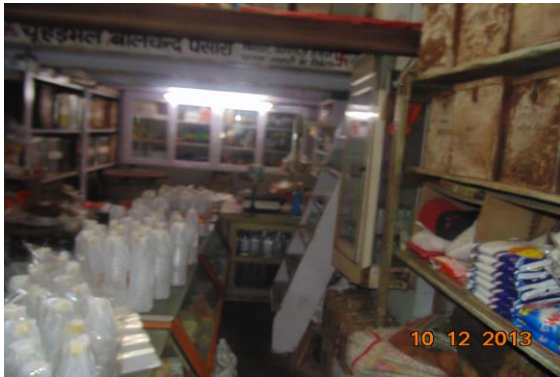
Photo 55

Wall No. 1 & 2 of Shop No.23 of Ground Floor Covered With wooden Racks & Material

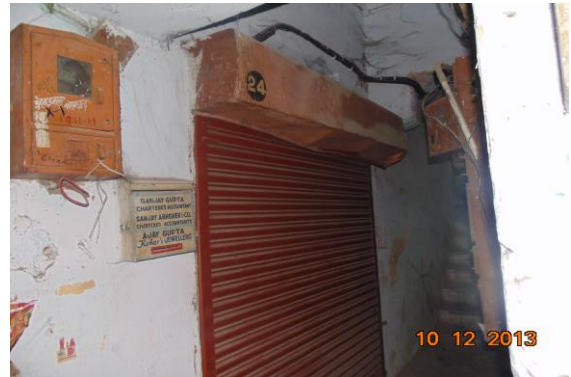
Photo 56

Shop No.24 of Ground Floor Locked, Nayar Bangles Godown

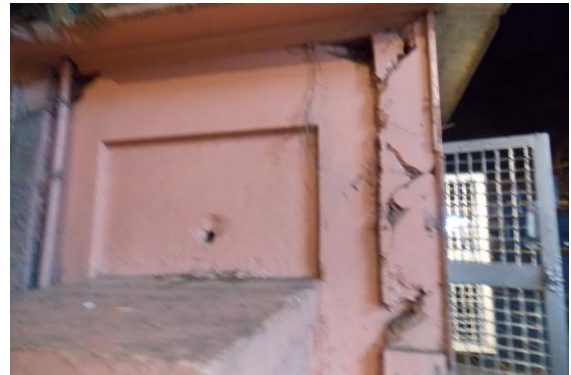
Photo 13
Side A View of Temple, Ground Floor

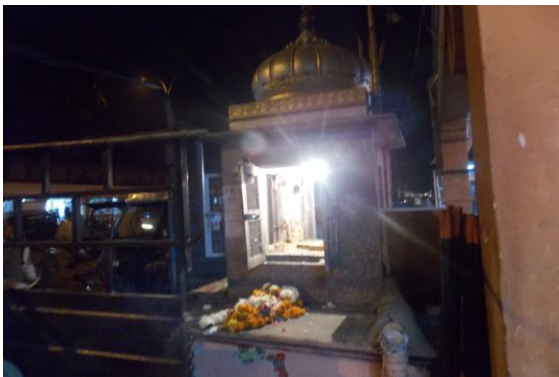
Photo 14
Backside View of Temple, Ground Floor

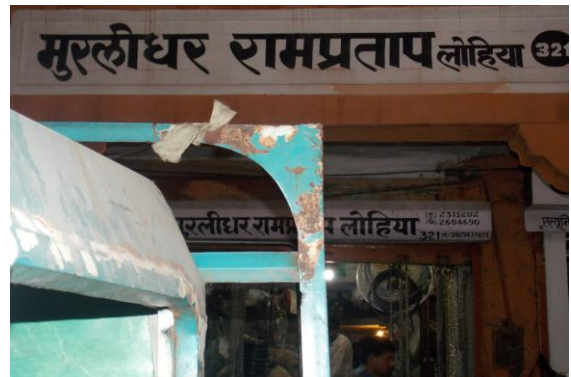
Photo 15
Side B View of Temple, Ground Floor

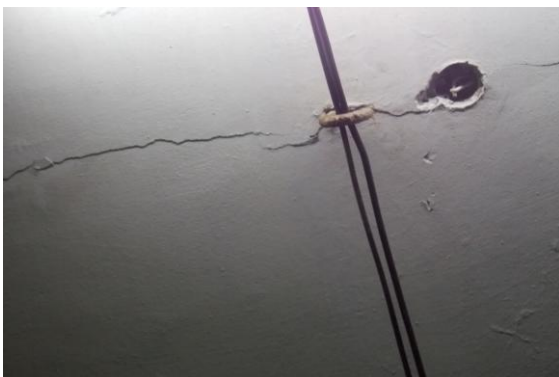
Summary of Cracks						
Defect ID	Location	Orientation	Appx. Width (mm)	Appx. Length (m)	Category	Photo No.
1	Roof Varanda of Shop No.328 & 329 Ground Floor	Horizontal	1	3	Slight	17
2	Shop No.330 Ground Floor	Horizontal	2	3	Slight	18
3	Roof Varanda of Shop No.327 Ground Floor	Horizontal	0.15	2.1	Very Slight	19
4	Roof Varanda of shop No.322 Ground Floor	Horizontal	3	2.5	Slight	20

Photo 16
View of Shop no.321, Ground Floor

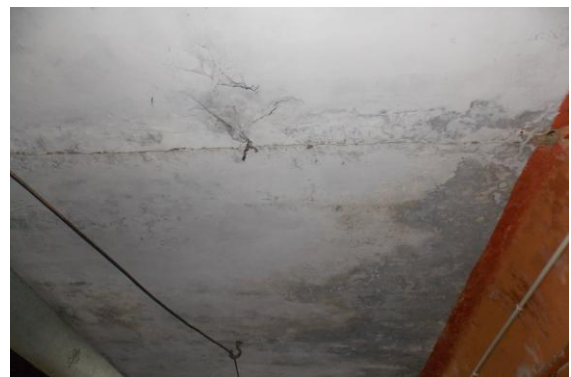
Photo 17
Horizontal Crack on Roof of Varanda of Shop No.328 & 329, Ground Floor, Approx. Width = 1mm, Approx. Length = 3m.
Distance from = Backside Rightside external Columnn, Height from Floor = 3m

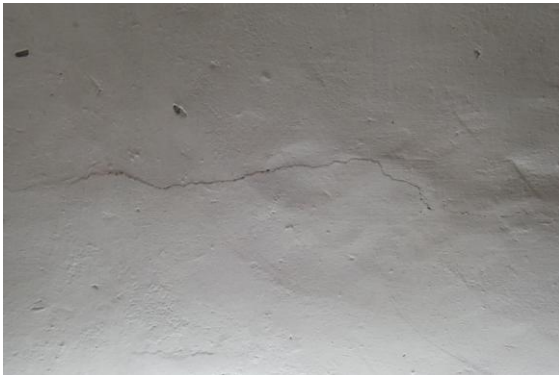
Photo 19

Horizontal Crack on Roof of Varanda of Shop No.327, Ground Floor,
Approx. Width = 0.15mm, Approx. Length = 2.1m.
Distance from Backside Rightside external Column = 0.5m, Height from
Floor = 3.5m

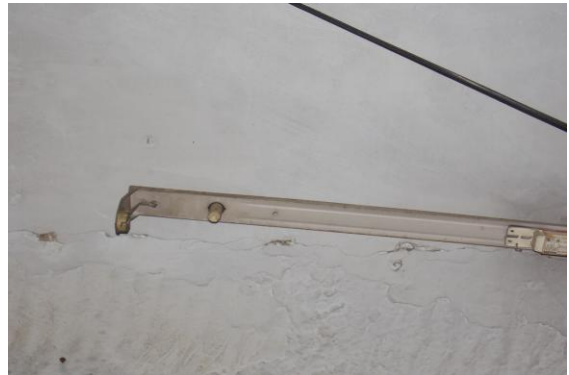
Photo 20

Horizontal Crack on Roof of Varanda of shop No.322, Ground Floor,
Approx. Width = 3mm, Approx. Length = 2.5m.
Distance from = Backside Rightside external Column, Height from
Floor = 3m

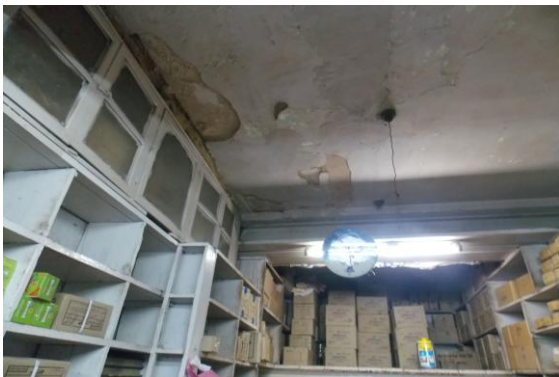
Photo 21

Summary of Defects Other Than Crack			
Defect ID	Location	Description	Photo No.
5	Roof Shop No.329 Ground Floor	Peeling of Plaster	21
6	Roof Shop No.329 Ground Floor	Peeling of Plaster	22
7	Roof Shop No.329 Basement	Peeling of Plaster	23
8	Roof Varanda of Shop No.328 & 329 Ground Floor	Peeling of Plaster	24
9	Roof Varanda of Shop No.328 & 329 Ground Floor	Dampness/Seepage	25
10	Wall No. 2 Shop No.330 Ground Floor	Damaged Portion	26
11	Wall No. 2 Shop No.330 Ground Floor	Damaged Portion	27
12	Roof Shop No.330 Ground Floor	Peeling of Plaster	28
13	Varanda of Shop No.326 Ground Floor	Peeling of Plaster	29
14	Roof Varanda of Shop no.325 Ground Floor	Dampness/Seepage	30
15	Roof Varanda of Shop No.324 Ground Floor	Dampness/Seepage	31
16	External Leftside Column Varanda of Shop No.324 Ground Floor	Peeling of Plaster	32
17	External Rightside Column Varanda of Shop No.324 Ground Floor	Peeling of Plaster	33
18	Roof Varanda of Shop No.323 Ground Floor	Peeling of Plaster	34

Peeling of Plaster on Roof of Shop No.329 of Ground Floor

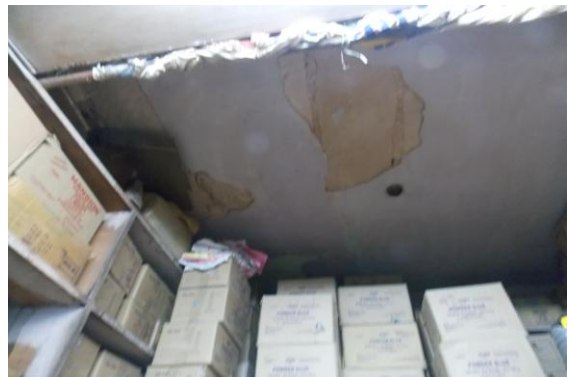
Photo 22

Peeling of Plaster on Roof of Shop No.329 of Ground Floor

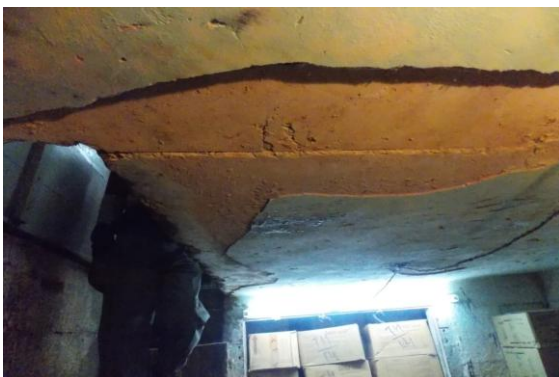
Photo 23

Peeling of Plaster on Roof of Shop No.329 of Basement

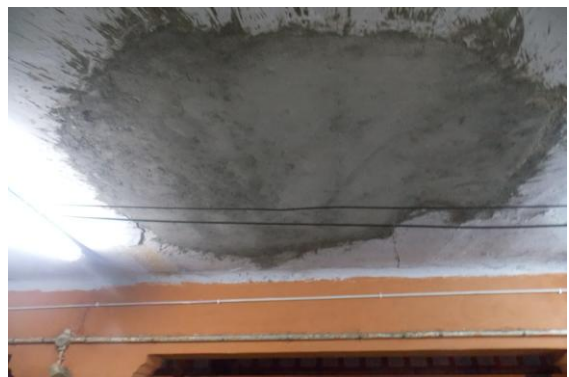
Photo 24

Peeling of Plaster on Roof of Varanda of Shop No.328 & 329 of Ground
Floor

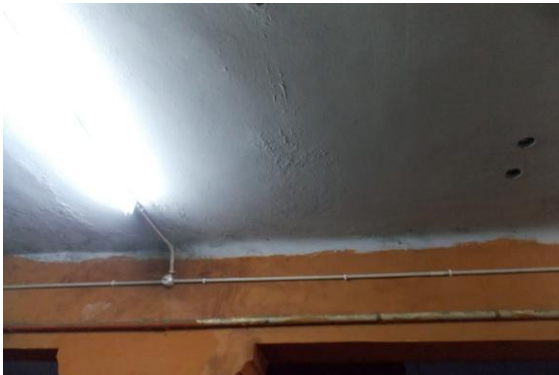
Photo 25

Dampness/Seepage on Roof of Varanda of Shop No.328 & 329 of Ground Floor

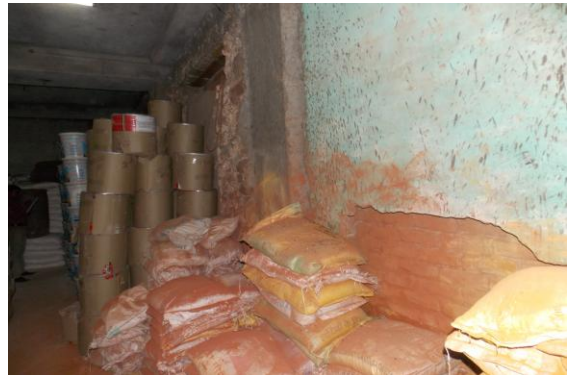
Photo 26

Damaged Portion on Wall No. 2 of Shop No.330 of Ground Floor

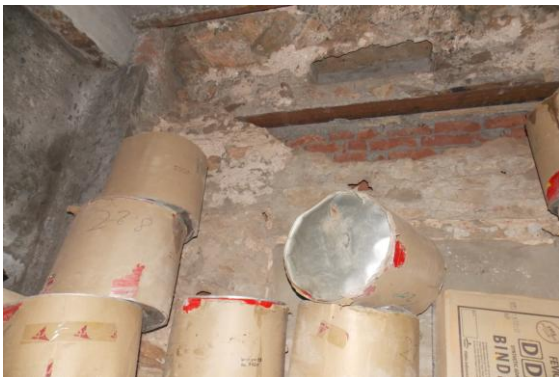
Photo 27

Damaged Portion on Wall No. 2 of Shop No.330 of Ground Floor

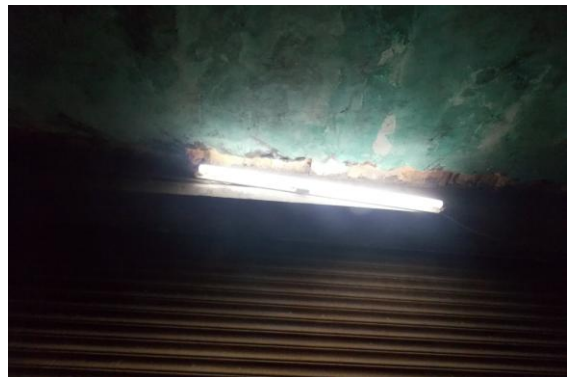
Photo 28

Peeling of Plaster on Roof of Shop No.330 of Ground Floor

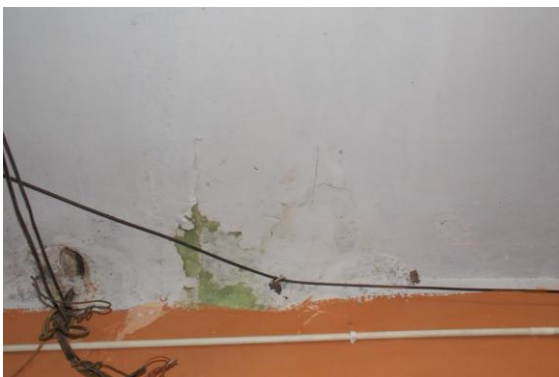
Photo 29

Peeling of Plaster on Varanda of Shop No.326 of Ground Floor

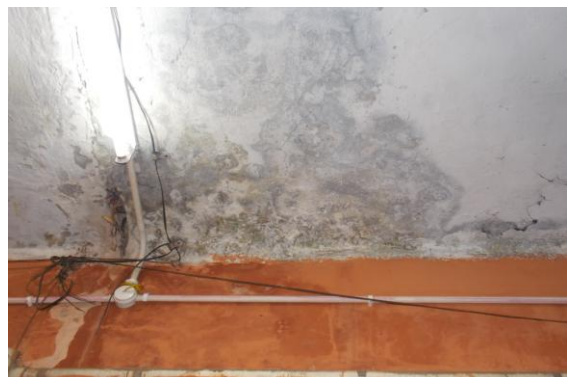
Photo 30

Dampness/Seepage on Roof of Varanda of Shop no.325 of Ground Floor

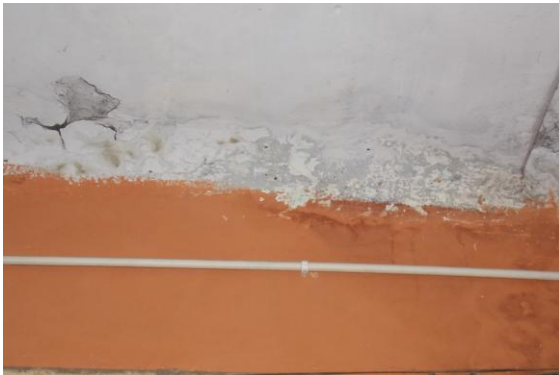
Photo 31
Dampness/Seepage on Roof of Varanda of Shop No.324 of Ground Floor

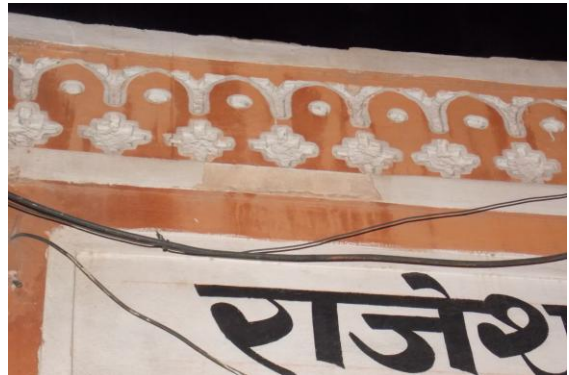
Photo 32
Peeling of Plaster on External Leftside Column of Varanda of Shop No.324 of Ground Floor

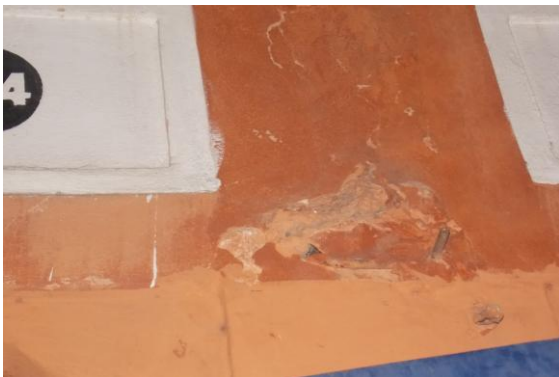
Photo 33
Peeling of Plaster on External Rightside Column of Varanda of Shop No.324 of Ground Floor

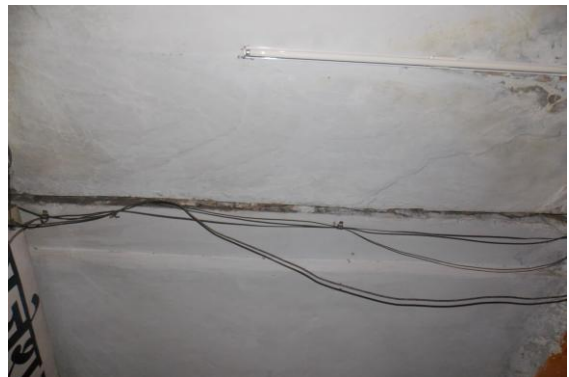
Photo 34
Peeling of Plaster on Roof of Varanda of Shop No.323 of Ground Floor

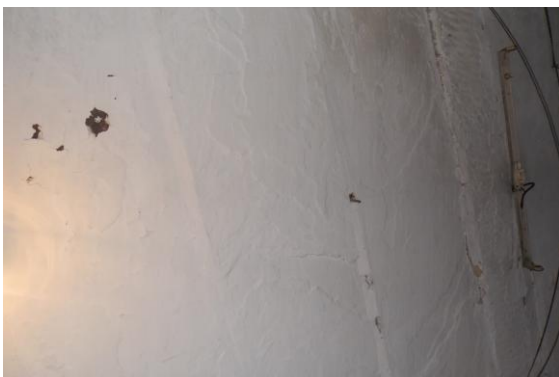
Photo 35
Peeling of Plaster on Roof of Varanda of Shop No.323 of Ground Floor

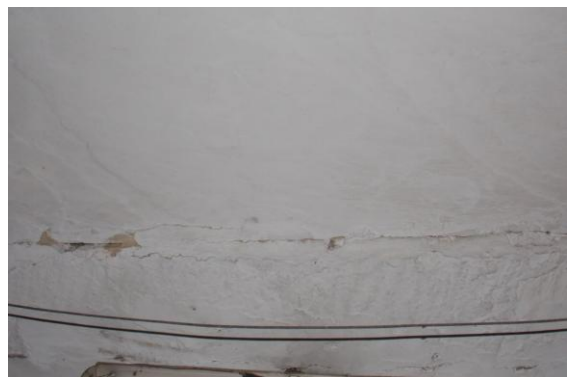
Photo 36
Exposed Reinforcement on Roof of Varanda of Shop No.323 of Ground Floor

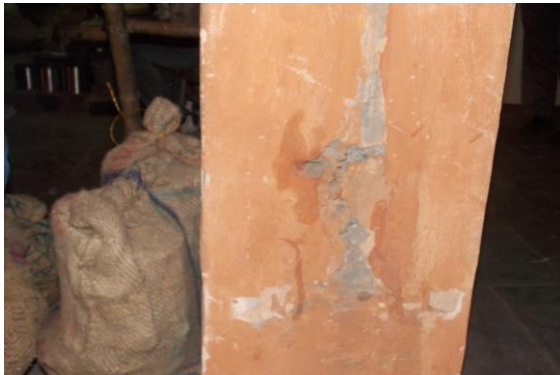
Photo 37

Peeling of Plaster on External Rightside Column of Varanda of Shop No.323 of Ground Floor

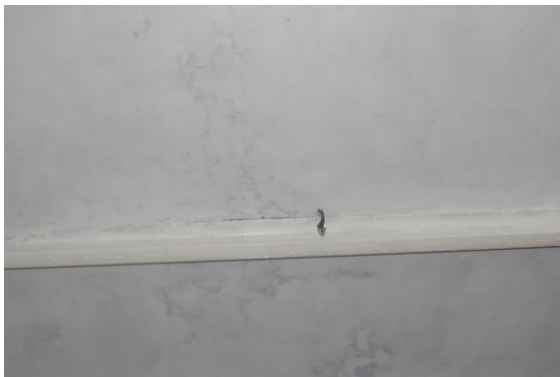
Photo 39

Dampness/Seepage on Roof of Part A of shop No.322 of Ground Floor

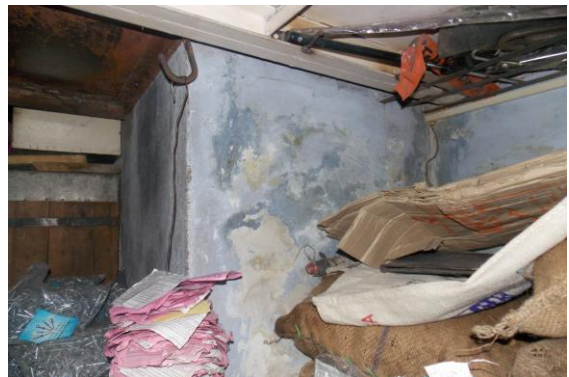
Photo 40

Dampness/Seepage on Wall No. 4 of Part A of shop No.322 of Ground Floor

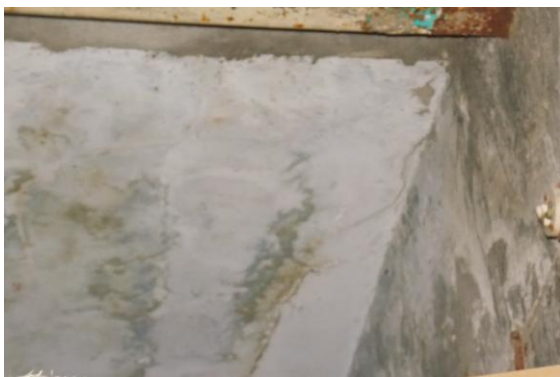
Photo 41

Peeling of Plaster on Roof of Part B of shop No.322 of Ground Floor

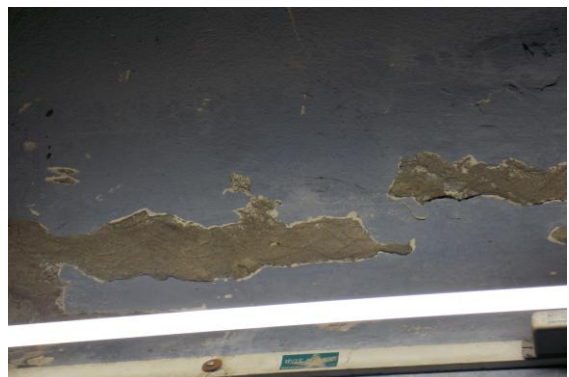
Photo 42

Peeling of Plaster on Roof of Part B of shop No.322 of Ground Floor

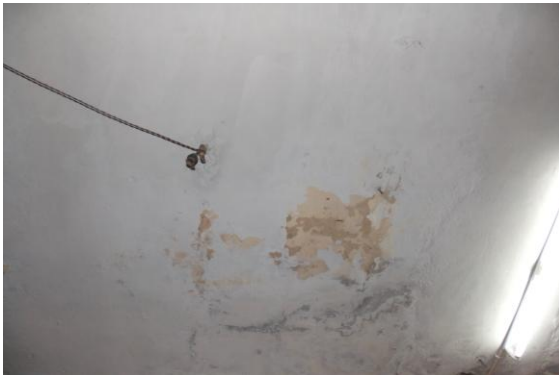
Photo 43

Peeling of Plaster on Roof of Varanda of shop No.322 of Ground Floor

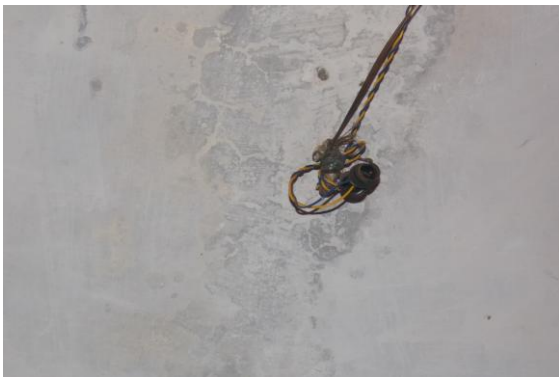
Photo 45

Dampness/Seepage on Roof of Varanda of Shop No.319 of Ground Floor

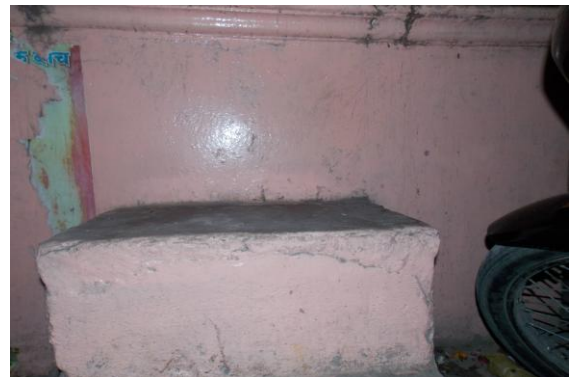
Photo 46

Peeling of Plaster on Steps of Staircase of Temple of Ground Floor

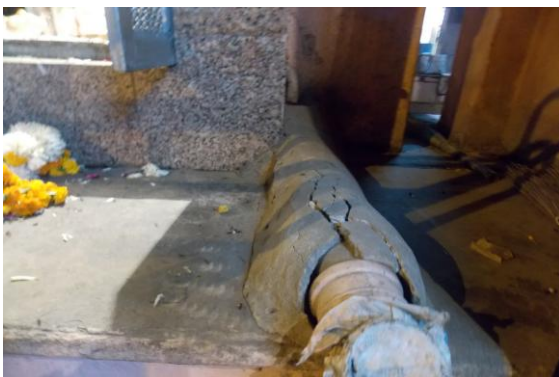
Photo 47

Damaged Portion on Side B of Temple of Ground Floor
