Pre Building Condition Survey Report

Name and Address of Structure :	Choti Chopar to Badi Chopar (Down Line)
---------------------------------	---

Name of the Project	Contract JMRC-UG1B “Design and Construction of Tunnel between Chandpole and Badi Chouper and reverse line by Shield TBM, Underground Metro Stations at Choti Chouper and Badi Chouper by Cut and Cover Methods on East West Corridor of Jaipur Metro Rail Corporation Limited .”	
Owner :

Pre Building Condition Survey Report Choti Chopar to Badi Chopar (Down Line)

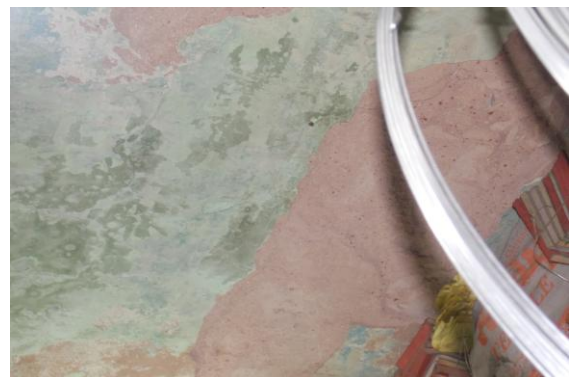
Photo 48

Dampness/Seepage on Roof of Part A of shop No.321 of Ground Floor

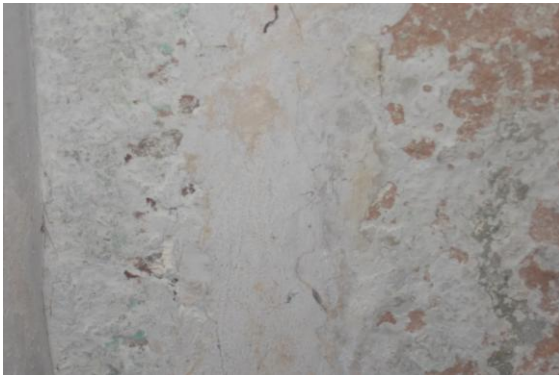
Photo 49

Peeling of Plaster on Roof of Part B of shop No.321 of Ground Floor

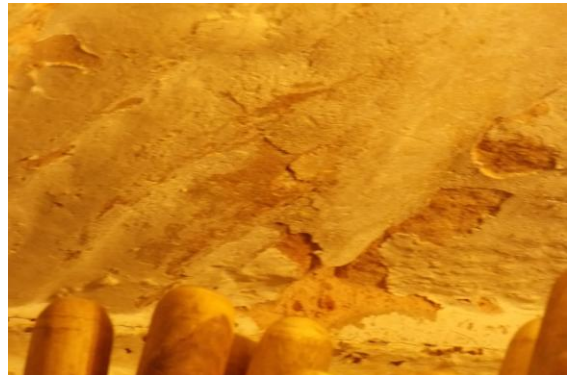
Photo 50

Peeling of Plaster on Roof of Part C of shop No.321 of Ground Floor

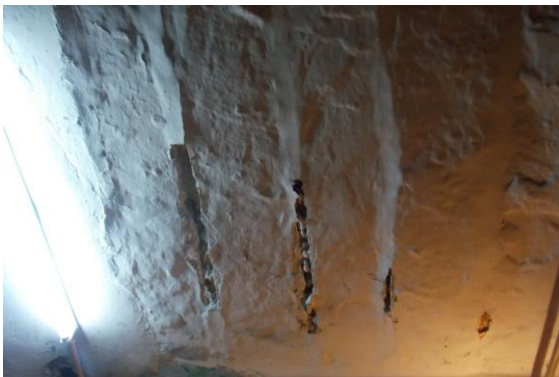
Photo 51

Peeling of Plaster on Roof of Varanda of shop No.321 of Ground Floor

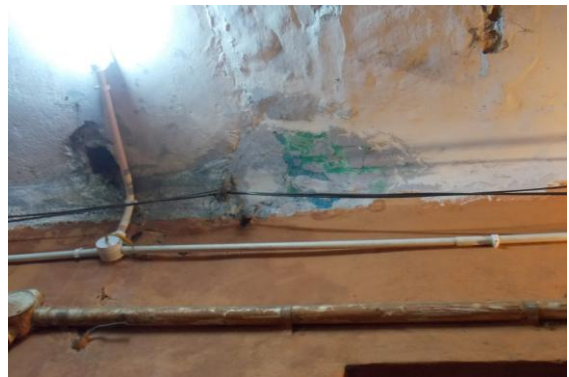
Photo 52

Dampness/Seepage on Roof of Varanda of shop No.321 of Ground Floor

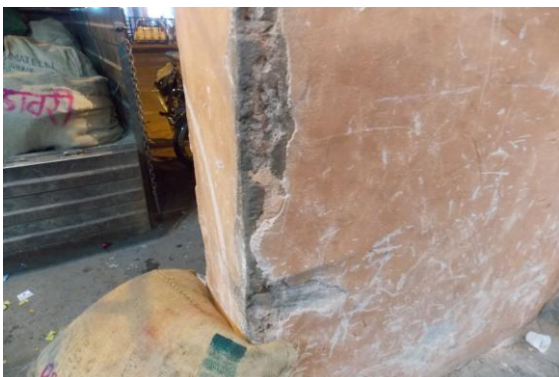
Photo 53

Peeling of Plaster on External Leftside Column of Varanda of shop No.321 of Ground Floor

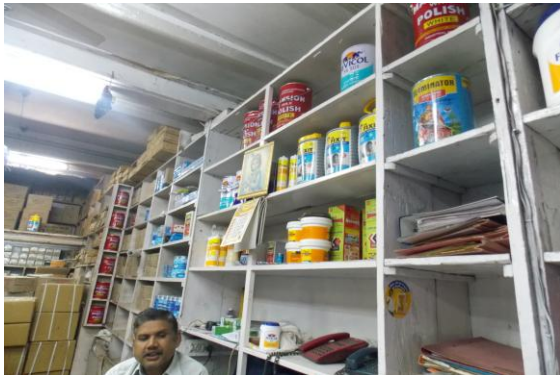
Photo 55

Wall No. 2 of Shop No.329 of Ground Floor Covered With Wooden Racks & Material

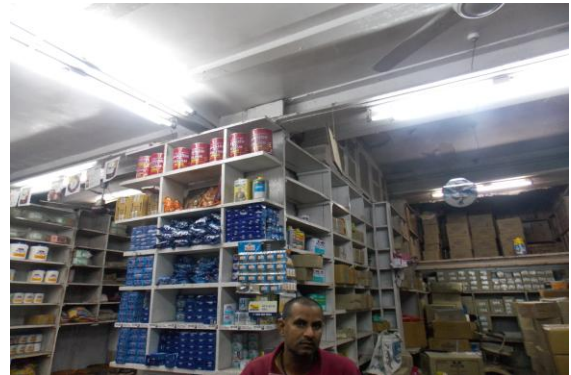
Photo 56

Wall No. 1 of Shop No.329 of Ground Floor Covered With Wooden Racks & Material

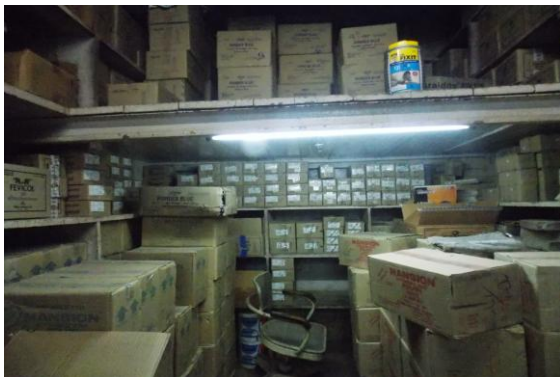
Photo 57

Wall No. 4 of Shop No.329 of Ground Floor Covered With Wooden Racks & Material

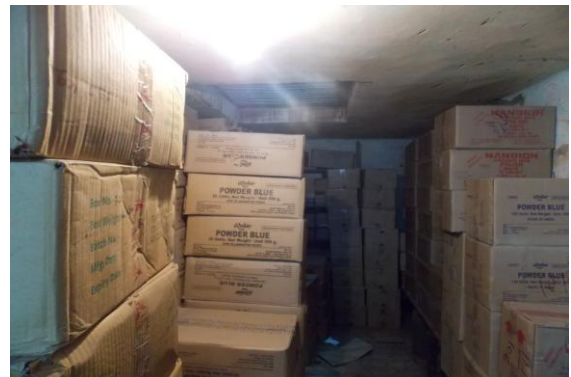
Photo 58

All Walls of Shop No.329 of Basement Covered With Wooden Racks & Material

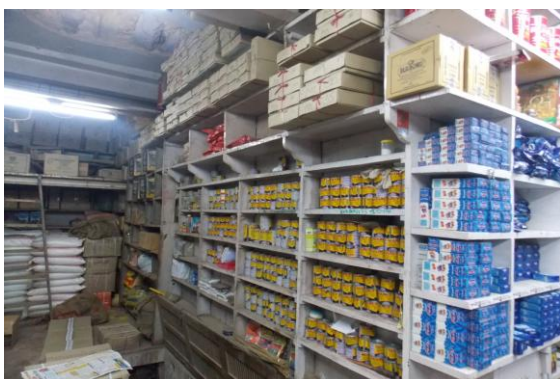
Photo 59

Wall No. 2 of Shop No.328 of Ground Floor Covered With Wooden Racks & Material

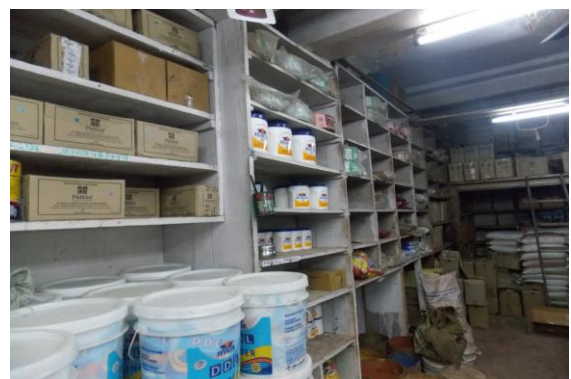
Photo 60

Wall No. 1 of Shop No.328 of Ground Floor Covered With Wooden Racks & Material

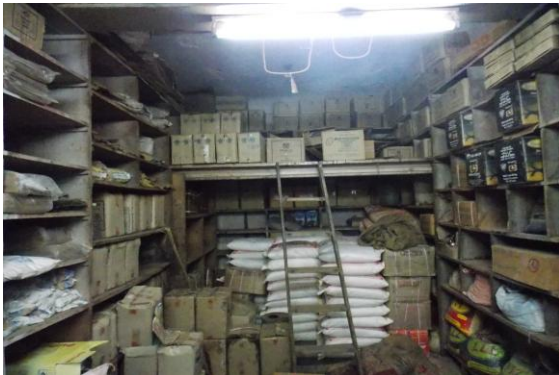
Photo 61

Wall No. 4 of Shop No.328 of Ground Floor Covered With Wooden Racks & Material

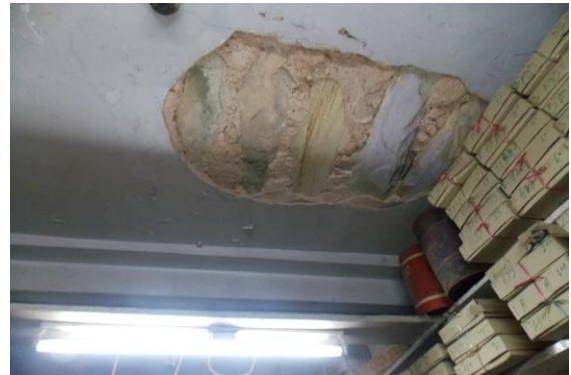
Photo 62

Roof of Shop No.328 of Ground Floor Covered With Wooden Work

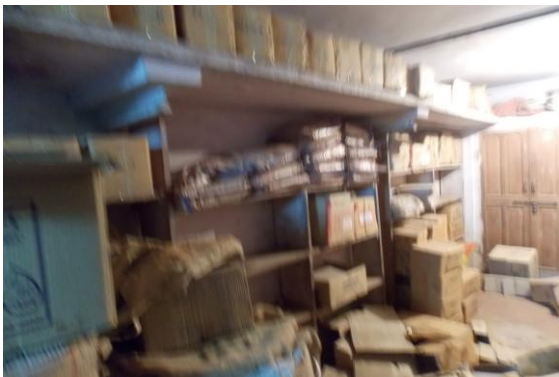
Photo 63

All Walls of Shop No.328 of Basement Covered With Wooden Racks & Material

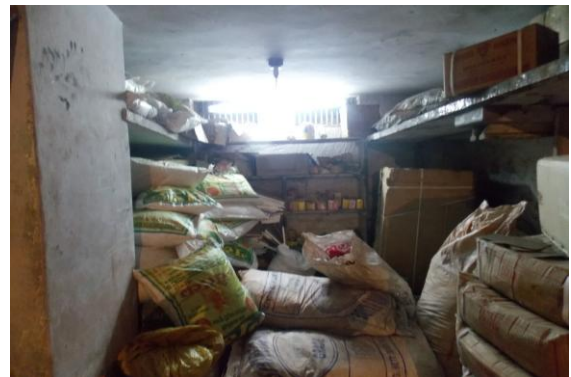
Photo 64

All Walls of Shop No.328 of Basement Covered With Wooden Racks & Material

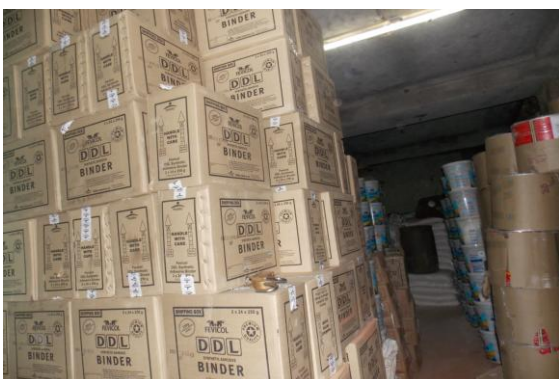
Photo 65

Wall No. 1, 2 & 4 of Shop No.330 of Ground Floor Covered With Wooden Racks & Material

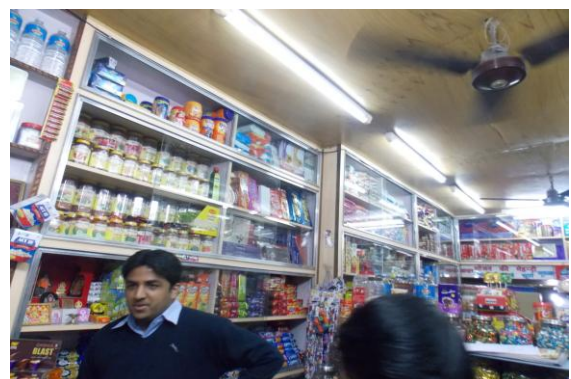
Photo 66

Wall No. 1 of Shop No.327 of Ground Floor Covered with Material

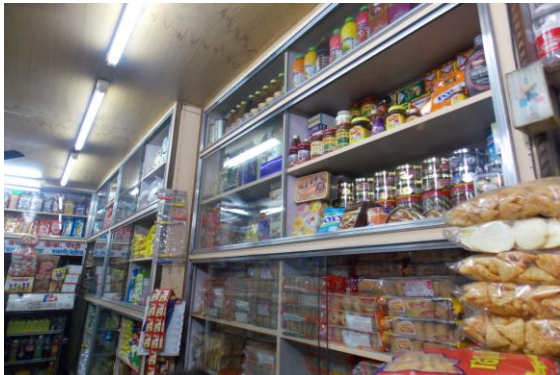
Photo 67

Wall No. 4 of Shop No.327 of Ground Floor Covered with Material

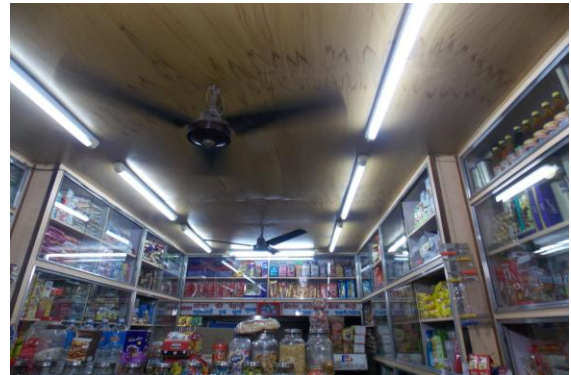
Photo 68

Wall No. 2 of Shop No.327 of Ground Floor Covered with Material

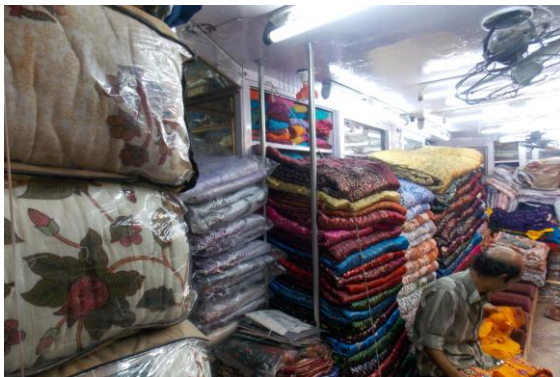
Photo 69

Wall No. 1 of Shop No.326 of Lower Ground Floor Covered With Wooden Racks & Material

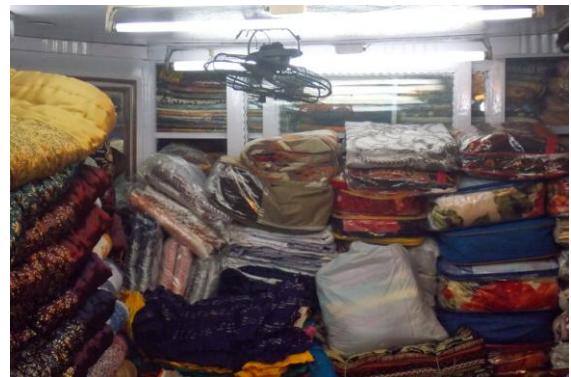
Photo 70

Wall No. 4 of Shop No.326 of Lower Ground Floor Covered With Wooden Racks & Material

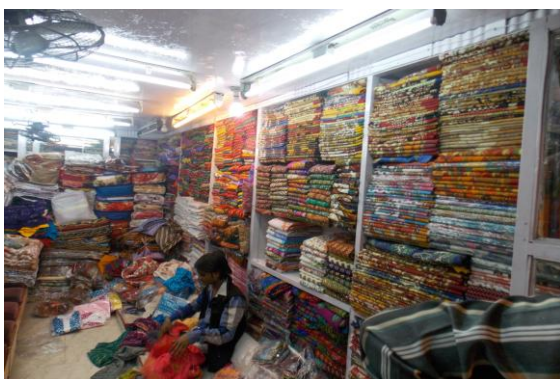
Photo 71

Wall No. 2 of Shop No.326 of Lower Ground Floor Covered With Wooden Racks & Material

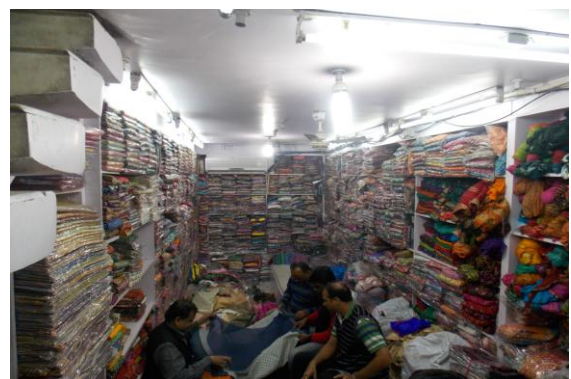
Photo 72

All Walls of Shop No.326 of Basement Covered With Wooden Racks & Material

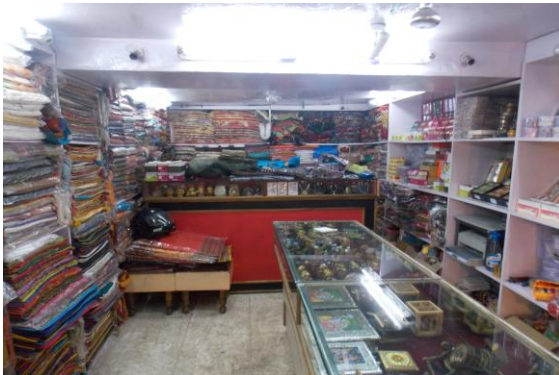
Photo 73

All Walls of Shop No.326 of Upper Ground Floor Covered With Wooden Racks & Material

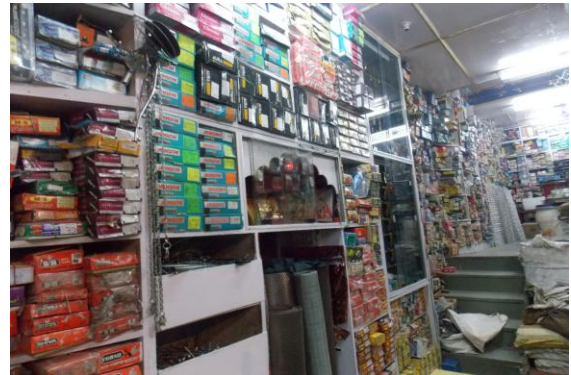
Photo 74

Wall No. 1 of Shop no.325 of Ground Floor Covered With Wooden Racks & Material

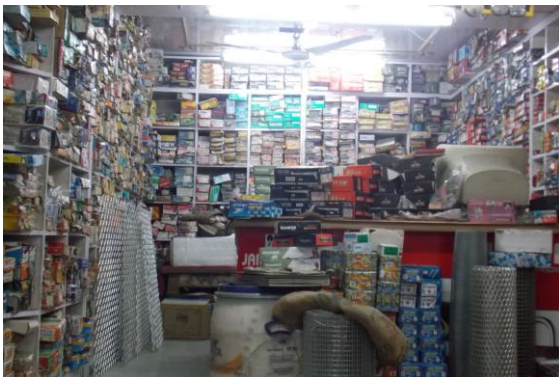
Photo 75

Wall No. 4 of Shop no.325 of Ground Floor Covered With Wooden Racks & Material

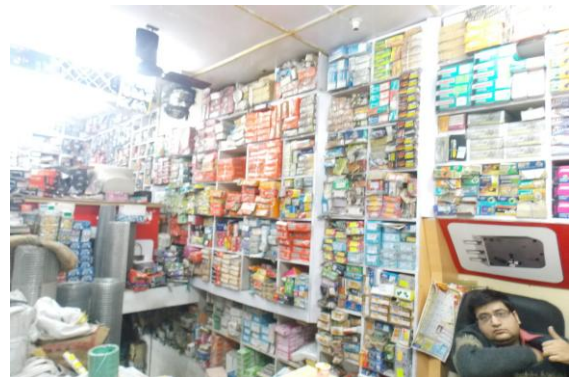
Photo 76

Wall No. 2 of Shop no.325 of Ground Floor Covered With Wooden Racks & Material

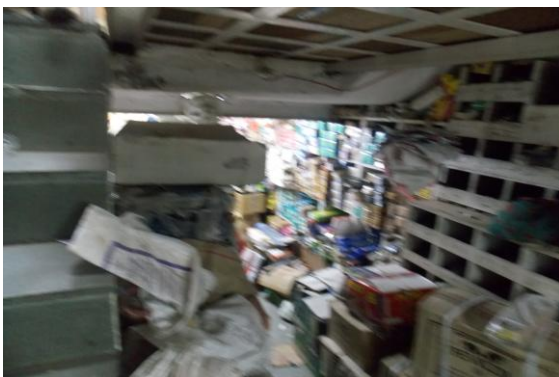
Photo 77

Wall No. 3 of Shop no.325 of Ground Floor Covered With Wooden Racks & Material

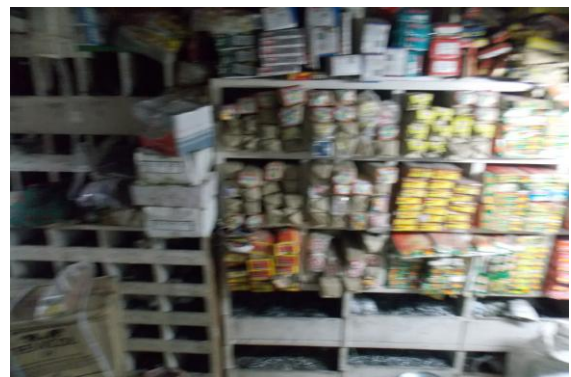
Photo 78

Wall No. 1 of Shop no.325 of Ground Floor Covered With Wooden Racks & Material

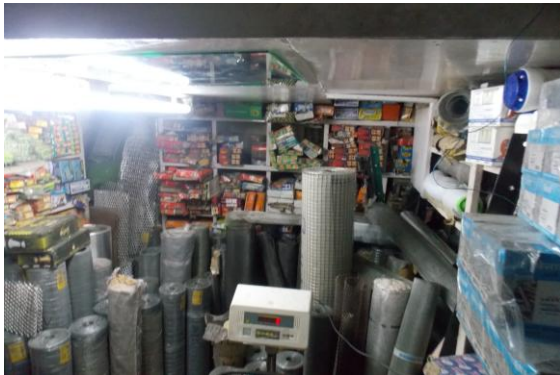
Photo 79

Wall No. 4 of Shop no.325 of Ground Floor Covered With Wooden Racks & Material

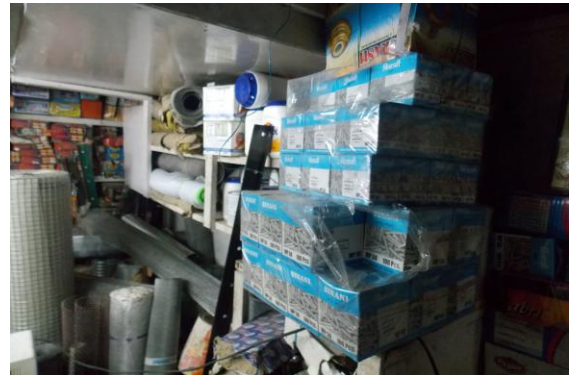
Photo 80

Wall No. 2 of Shop no.325 of Ground Floor Covered With Wooden Racks & Material

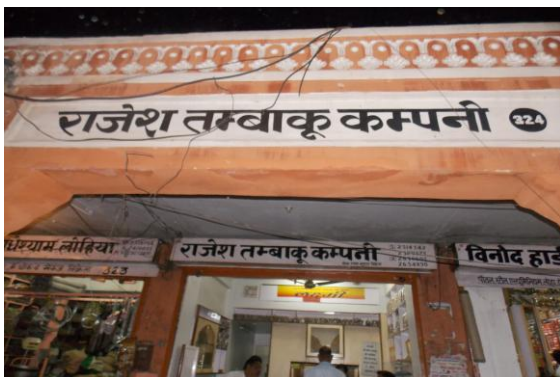
Photo 81

Wall No. 2 of Shop No.324 of Ground Floor Covered With Material

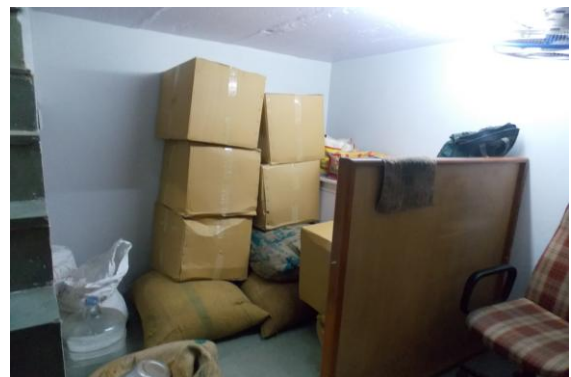
Photo 82

Wall No. 4 of Shop No.324 of Ground Floor Covered With Material

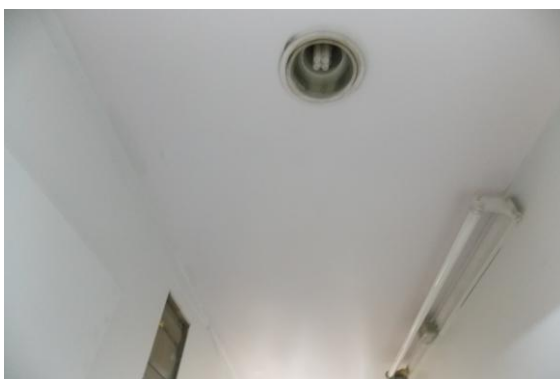
Photo 83

Roof of Shop No.324 of Ground Floor Covered With Falls Ceiling

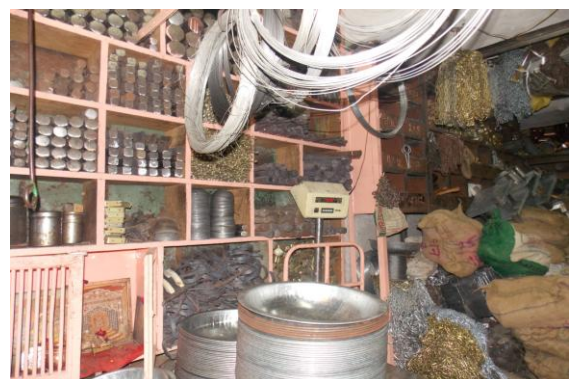
Photo 84

Wall No. 1 of Shop No.323 of Ground Floor Covered With Wooden Racks & Material

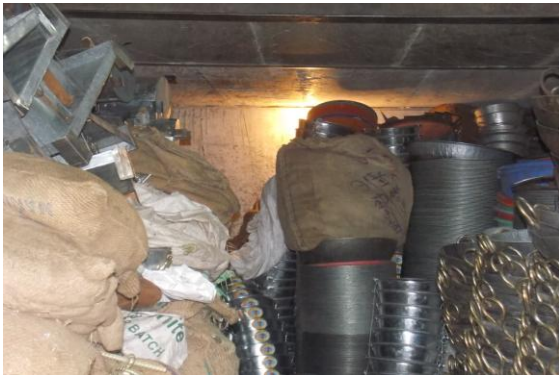
Photo 85

Wall No. 4 of Shop No.323 of Ground Floor Covered With Wooden Racks & Material

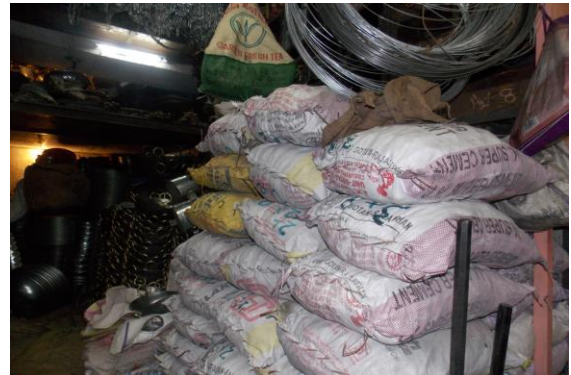
Photo 86

Wall No. 2 of Shop No.323 of Ground Floor Covered With Wooden Racks & Material

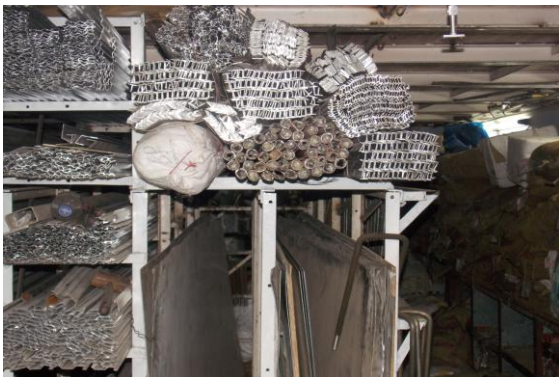
Photo 87

Wall No. 4 of Part A of shop No.322 of Ground Floor Covered With Material

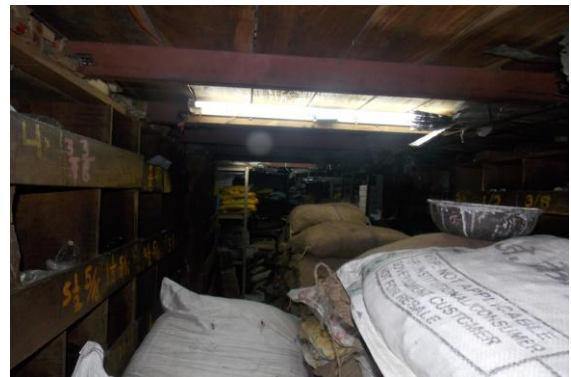
Photo 88

Wall No. 1, 3 & 5 of Part B of shop No.322 of Ground Floor Covered With Wooden Racks & Material

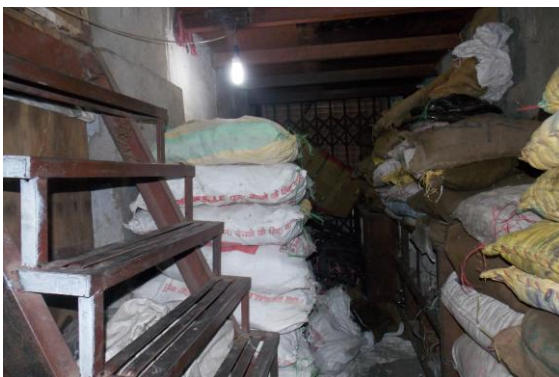
Photo 89

Wall No. 4 & 6 of Part B of shop No.322 of Ground Floor Covered With Wooden Racks & Material

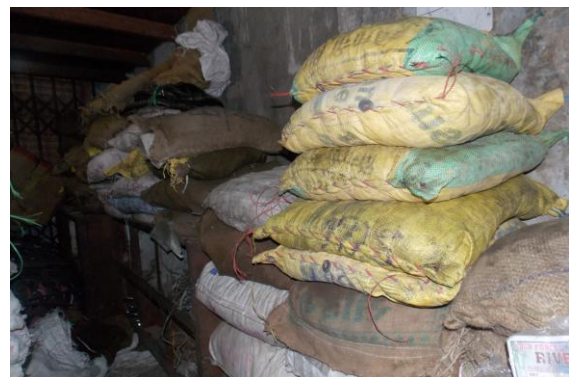
Photo 90

Wall No. 2 of Part B of shop No.322 of Ground Floor Covered With Wooden Racks & Material

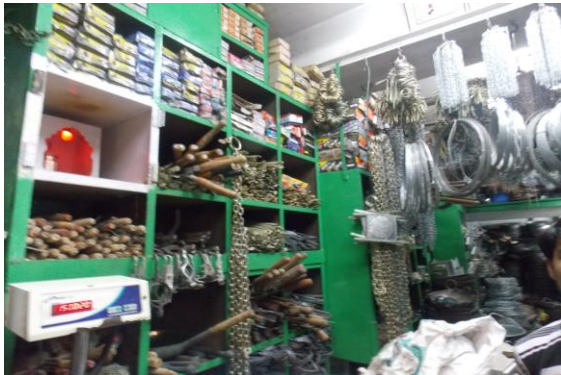
Photo 91

Wall No. 1 of Shop No.320 of Ground Floor Covered With Material

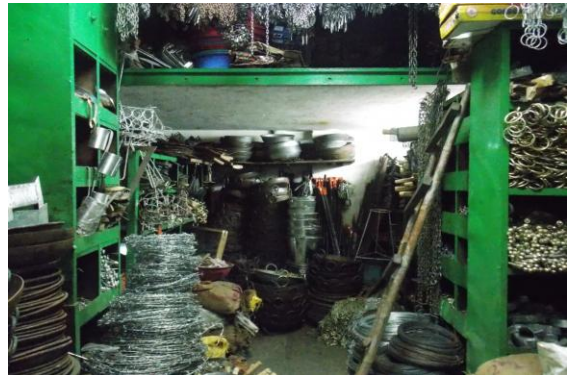
Photo 92

Wall No. 4 of Shop No.320 of Ground Floor Covered With Material

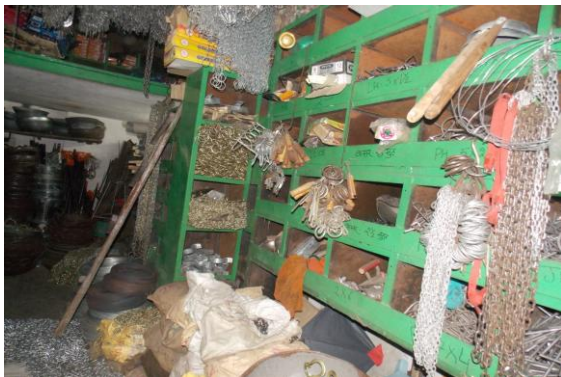
Photo 93

Wall No. 2 of Shop No.320 of Ground Floor Covered With Material

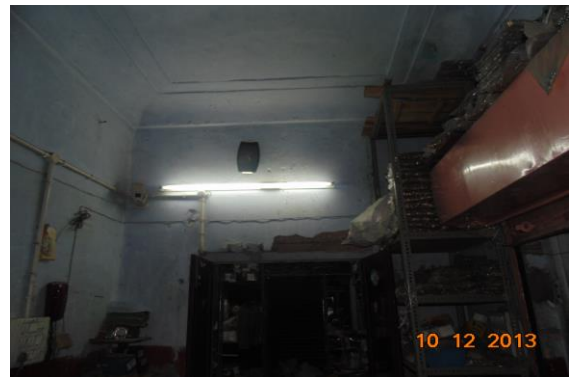
Summary of Defects Other Than Crack			
Defect ID	Location	Description	Photo No.
1	Roof & Front Lobby of shop no.115 First Floor	Peeling of Plaster	9
2	Wall No. 4 Part-I of Shop no.115 First Floor	Peeling of Plaster	10
3	Roof Part-I of Shop no.115 First Floor	Peeling of Plaster	11
4	Wall No. 1 Part-II of Shop no.115 First Floor	Peeling of Plaster	12
5	Roof Part-II of Shop no.115 First Floor	Peeling of Plaster	13
6	Outer wall Shade Roof Shop no.312 to 314 Third Floor	Dampness/Seepage	14
7	Wall No. 4 & Roof Part-III of Shop no.115 First Floor	Peeling of Plaster	15
8	Roof Part-IV of Shop No.115 First Floor	Peeling of Plaster	16
9	Wall No. 1 & Roof Part-IV of Shop No.115 First Floor	Peeling of Plaster	17
10	Wall No. 3 Part-IV of Shop No.115 First Floor	Peeling of Plaster	18
11	Roof Part-V-of Shop No.115 First Floor	Peeling of Plaster	19
12	Roof Part-VI of Shop No.115 First Floor	Peeling of Plaster	20
13	Roof Part-VII of Shop No.115 First Floor	Peeling of Plaster	21

Photo 10
Peeling of Plaster on Wall No. 4 of Part-I of Shop no.115 of First Floor

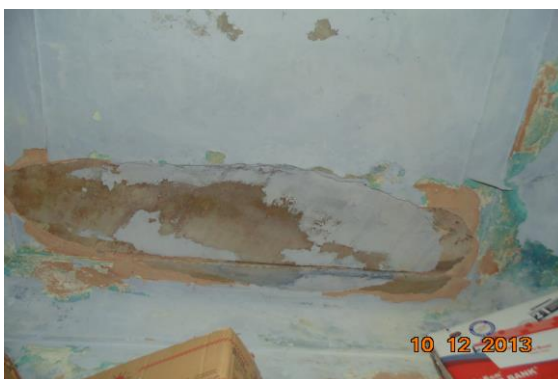
Photo 11
Peeling of Plaster on Roof of Part-I of Shop no.115 of First Floor

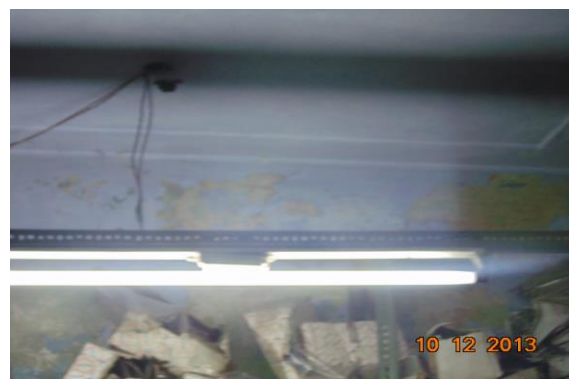
Photo 12
Peeling of Plaster on Wall No. 1 of Part-II of Shop no.115 of First Floor

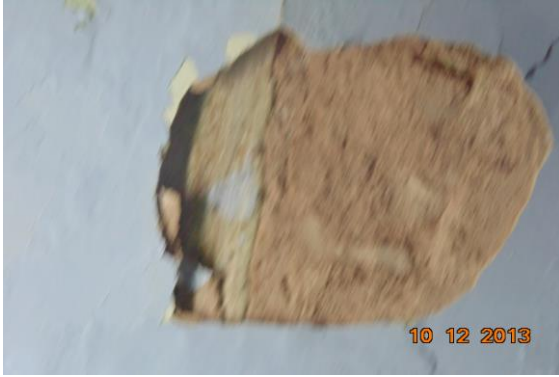
Photo 13
Peeling of Plaster on Roof of Part-II of Shop no.115 of First Floor

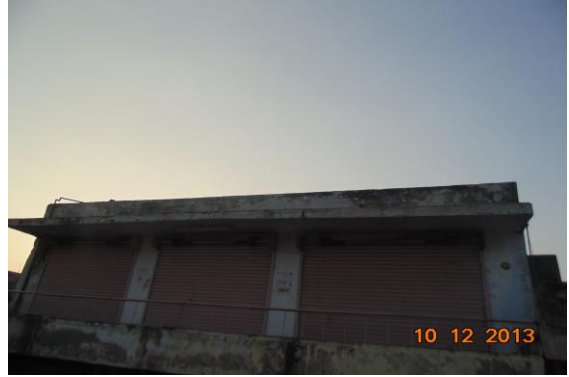
Photo 14
Dampness/Seepage on Outer wall Shade Roof of Shop no.312 to 314 of Third Floor

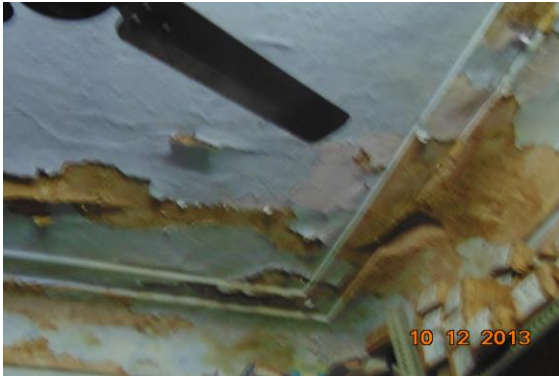
Photo 15
Peeling of Plaster on Wall No. 4 & Roof of Part-III of Shop no.115 of First Floor

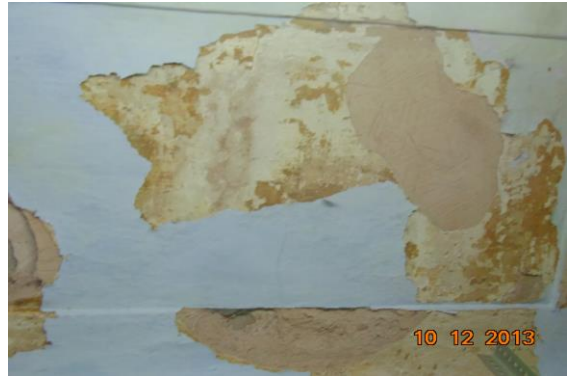
Photo 16
Peeling of Plaster on Roof of Part-IV of Shop No.115 of First Floor

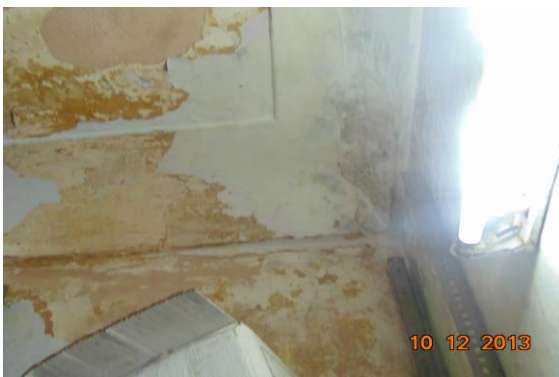
Photo 17
Peeling of Plaster on Wall No. 1 & Roof of Part-IV of Shop No.115 of First Floor

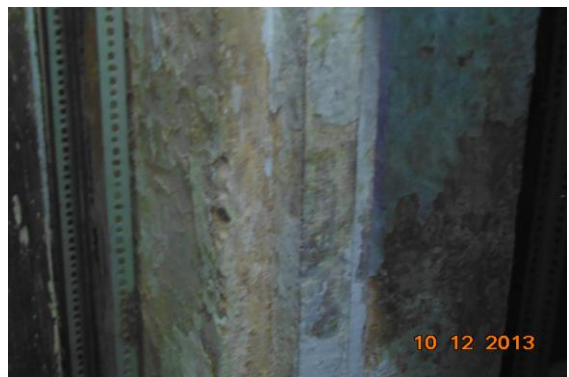
Photo 18
Peeling of Plaster on Wall No. 3 of Part-IV of Shop No.115 of First Floor

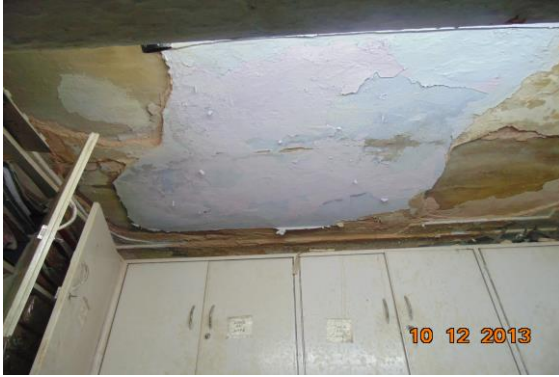
Photo 19

Peeling of Plaster on Roof of Part-V of Shop No.115 of First Floor

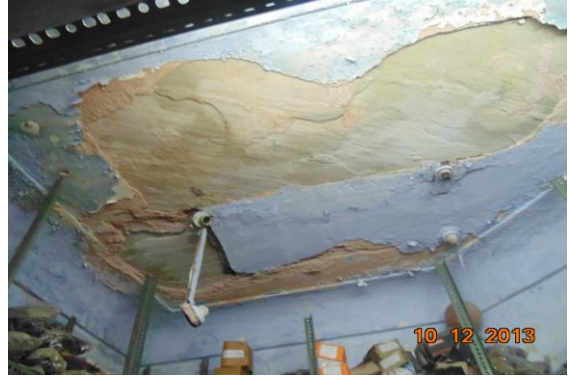
Photo 20

Peeling of Plaster on Roof of Part-VI of Shop No.115 of First Floor

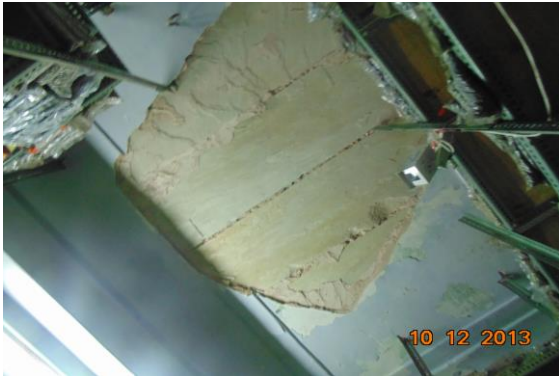
Photo 21

Peeling of Plaster on Roof of Part-VII of Shop No.115 of First Floor

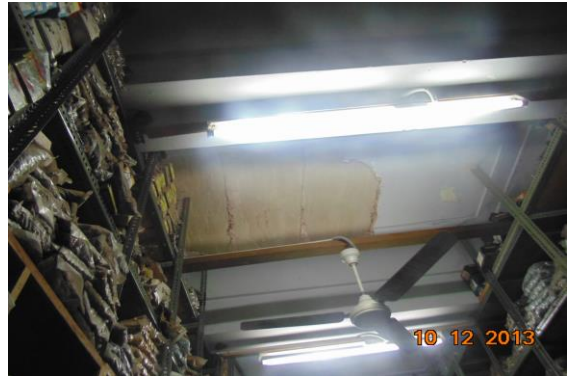
Photo 22

Peeling of Plaster on Roof of Part-VII of Shop No.115 of First Floor

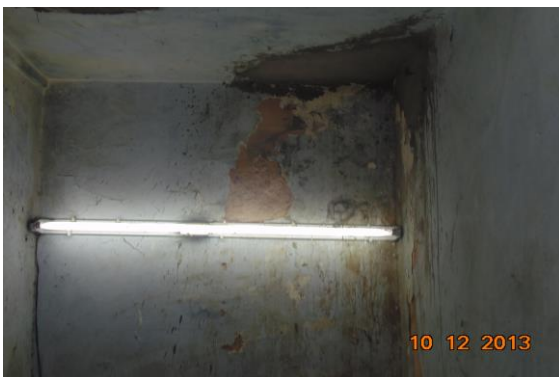
Photo 23

Dampness/Seepage on All walls of Stair Case Area of Ground Floor To First Floor of First Floor

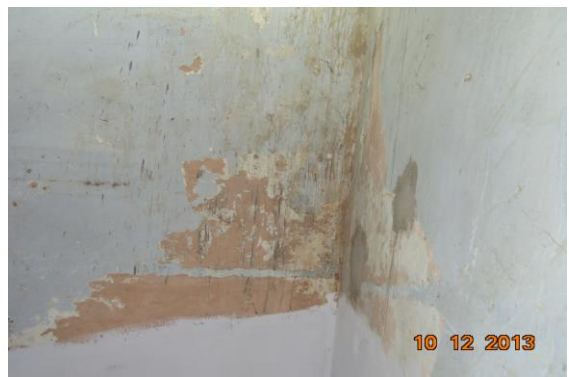
Photo 24

Dampness/Seepage on All walls of Stair Case Area of Ground Floor To First Floor of First Floor

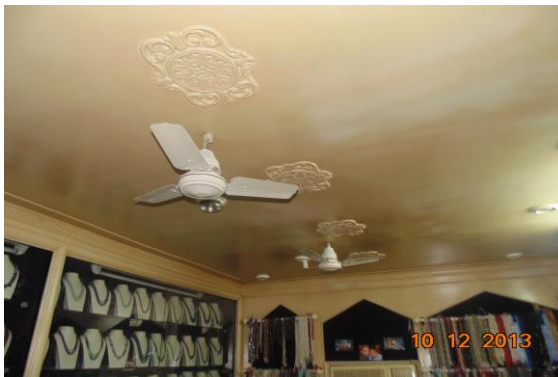
Photo 32

All walls of Shop no.212 & 213 of Second Floor Covered With Wooden Work

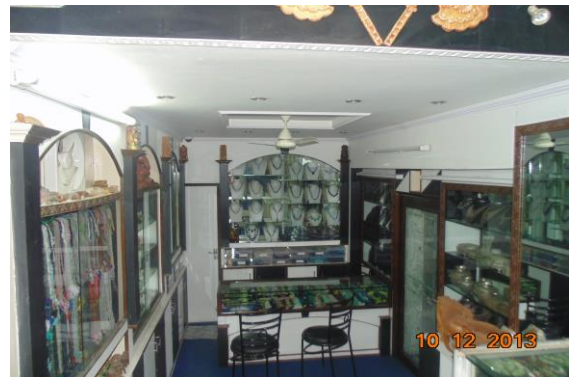
Photo 33

Roof of Shop no.212 & 213 of Second Floor Covered With falls ceiling

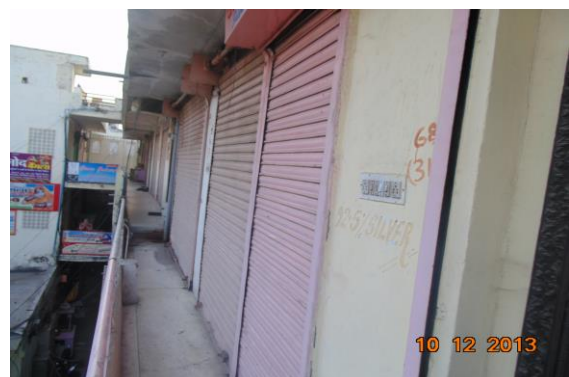
Photo 35

Roof of Shop No.214 of Second Floor Covered With Falls Ceiling

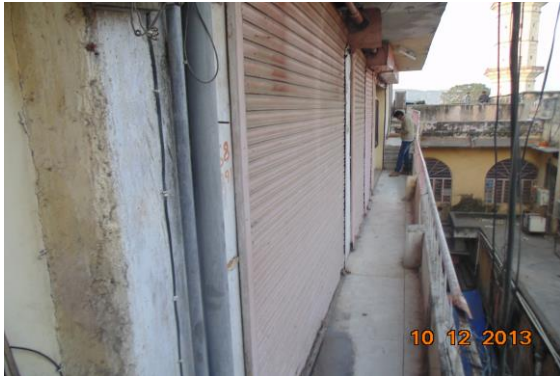
Photo 36

Shop No.215 & 216 of Second Floor Locked

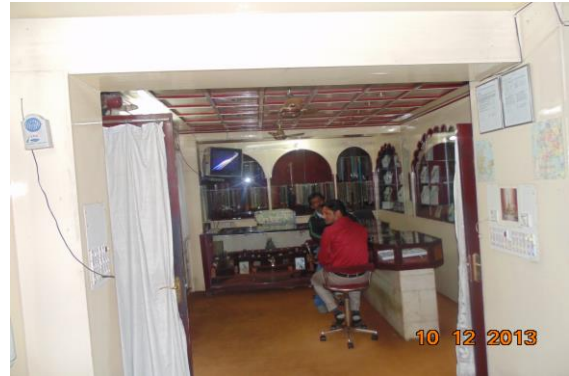
Photo 37
Shop No.215 & 216 of Second Floor Locked

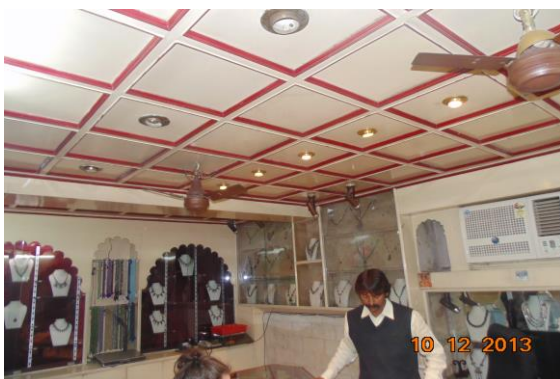
Photo 40
Roof of Shop No.114 to 112A of First Floor Covered with Falls Ceiling

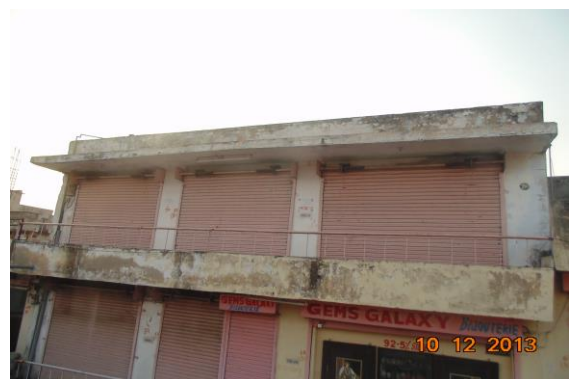
Photo 41
Shop No.114 to 112A of First Floor View of Wooden Partition

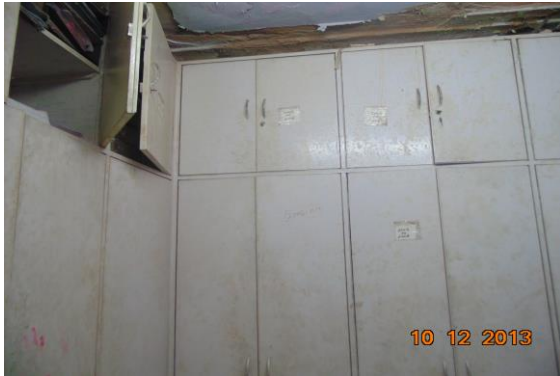
Photo 42
Shop no.312 to 314 of Third Floor Locked

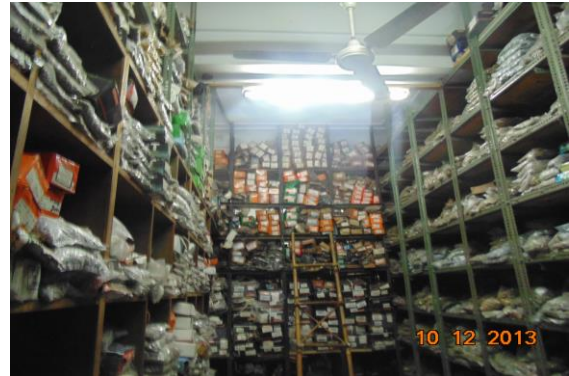
Photo 43

Wall No. 1 & 4 of Part-V of Shop No.115 of First Floor Covered With Wooden

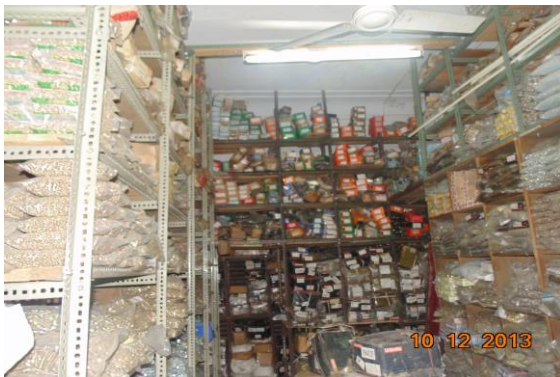
Photo 44

All walls of Shop of First Floor Covered With Material

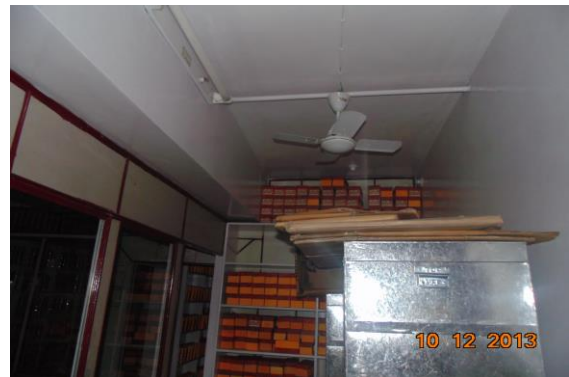
Photo 45

All walls of Shop of First Floor

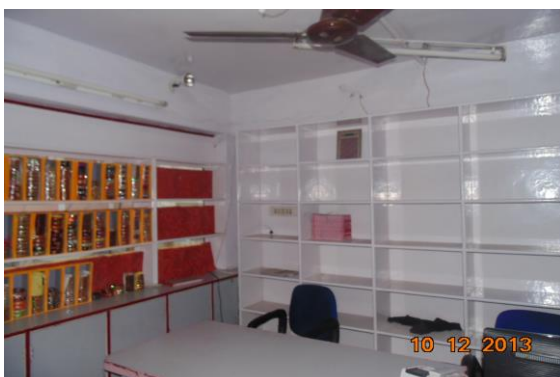
Photo 46

All walls of Shop No.111 & 112A of First Floor Covered With Racks & Material

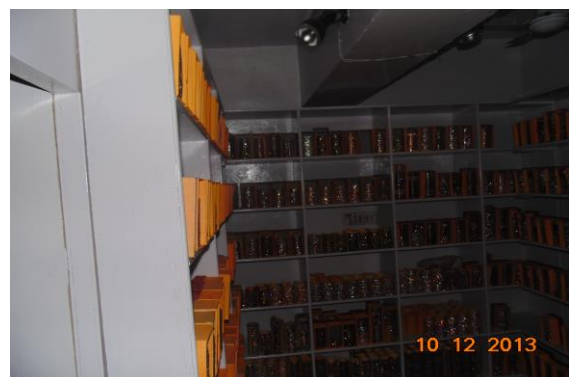
Photo 47

All walls of Shop No.111 & 112A of First Floor Covered With Racks & Material

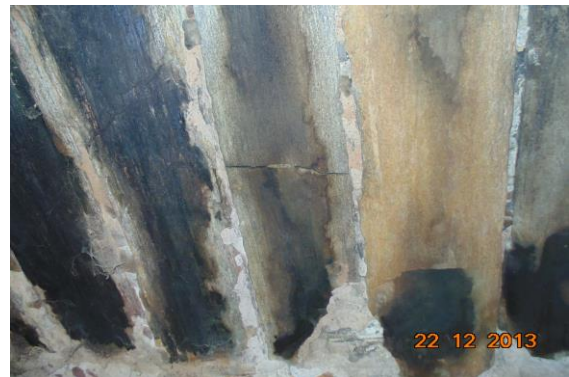
Summary of Cracks						
Defect ID	Location	Orientation	Appx. Width (mm)	Appx. Length (m)	Category	Photo No.
1	Roof Varanda of H.No.156 Ground Floor	Inclined	2.5	1	Slight	4
2	Roof Varanda of H.No.156 Ground Floor	Inclined	2.5	1	Slight	5
3	Wall No. 4 & Roof Ground Floor	Inclined	2	3	Slight	6

Photo 4
Inclined Crack on Roof of Varanda of H.No.156, Ground Floor Approx.
Width = 2.5mm, Approx. Length = 1m. Distance from = m, Height from Floor = m.

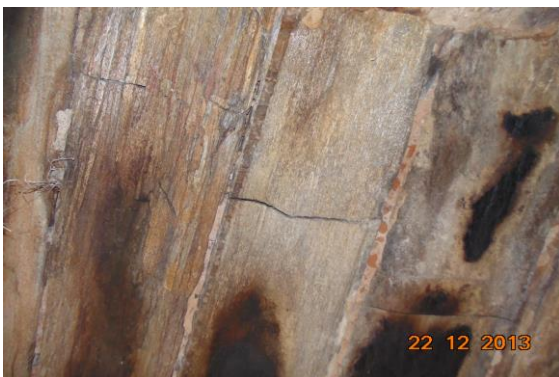
Photo 5
Inclined Crack on Roof of Varanda of H.No.156, Ground Floor Approx.
Width = 2.5mm, Approx. Length = 1m. Distance from = m, Height from Floor = m.

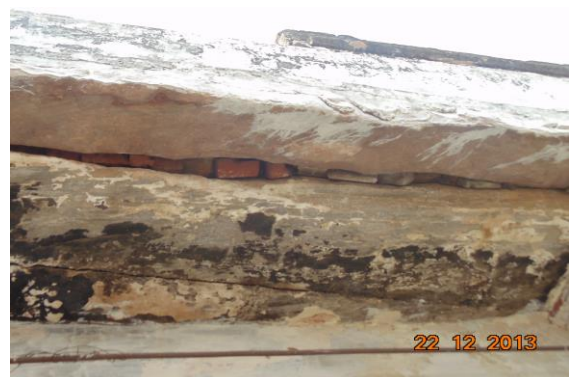
Photo 6
Inclined Crack on Wall No. 4 & Roof of , Ground Floor
Approx. Width = 2mm, Approx. Length = 3m.
Distance from = m, Height from Floor = m.

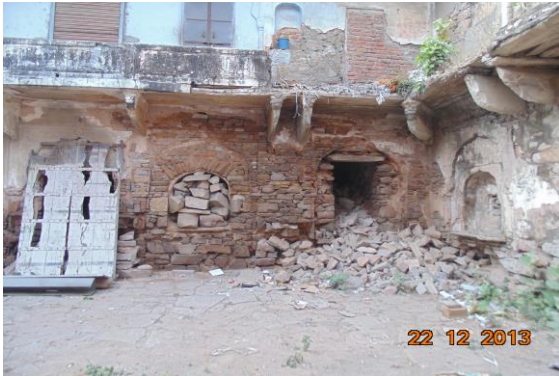
Photo 7

Peeling of Plaster on Damaged Portion of Courtyard, Part C, H. No.156 of Ground Floor

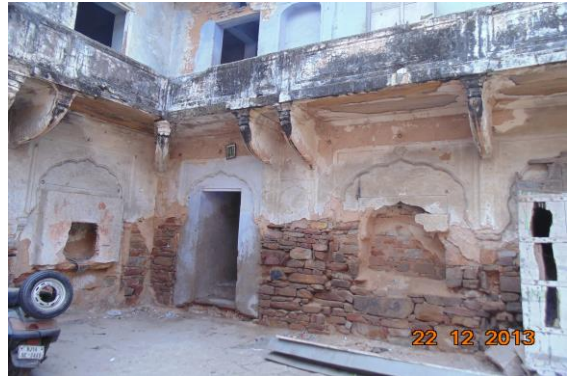
Photo 8

Peeling of Plaster on Damaged Portion of Courtyard, Part C, H. No.156 of Ground Floor

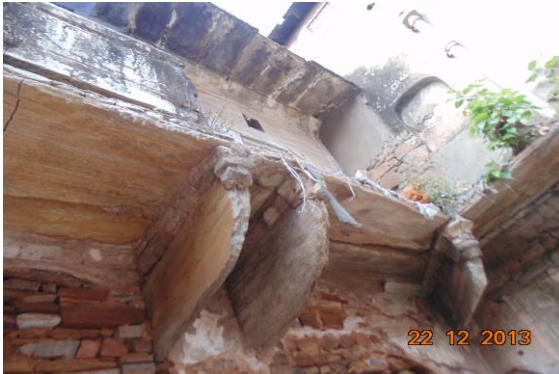
Photo 9

Peeling of Plaster on Damaged Portion of Courtyard, Part C, H. No.156 of Ground Floor

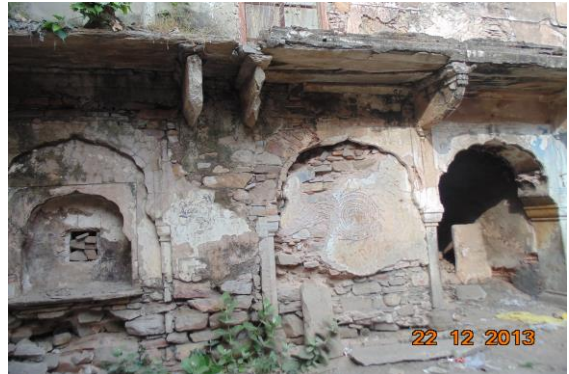
Photo 10

Peeling of Plaster on Damaged Portion of Courtyard, Part C, H. No.156 of Ground Floor

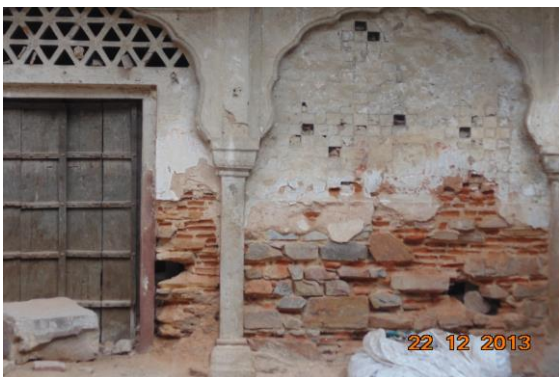
Photo 11

Peeling of Plaster on Damaged Portion of Courtyard, Part C, H. No.156 of Ground Floor

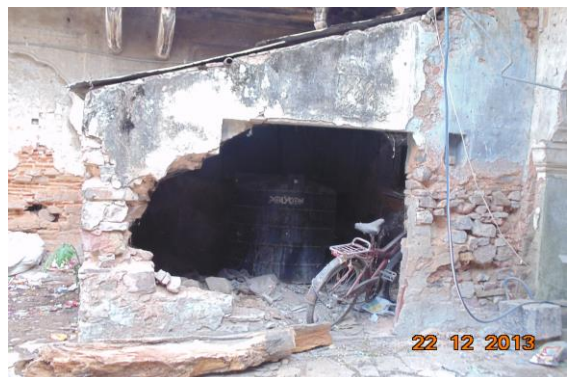
Photo 12

Peeling of Plaster on Damaged Portion of Courtyard, Part C, H. No.156 of Ground Floor

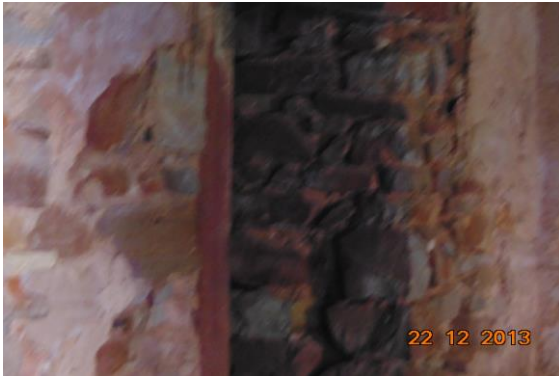
Photo 13

Peeling of Plaster on All walls of Varanda of H.No.156 of Ground Floor

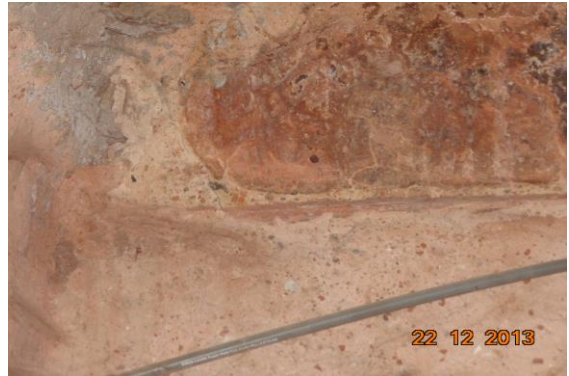
Photo 14

Peeling of Plaster on Roof of Varanda of H.No.156 of Ground Floor

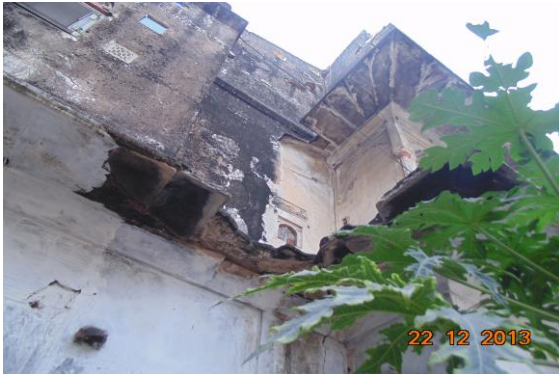
Photo 15

Peeling of Plaster on Wall No. 1 & Chajja of Open area Part B of Ground Floor

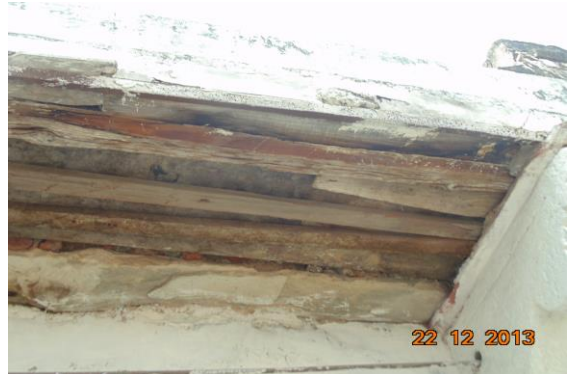
Photo 16

Peeling of Plaster on Wall No. 4 & Roof of Open area Part B of Ground Floor

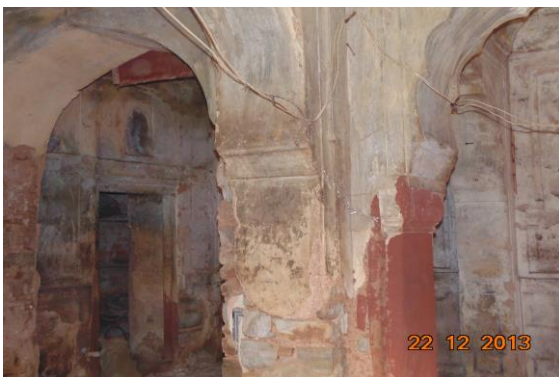
Photo 17

Peeling of Plaster & Damaged Portion All Walls of Hall No. 5, Part B of H. No.156 of Ground Floor

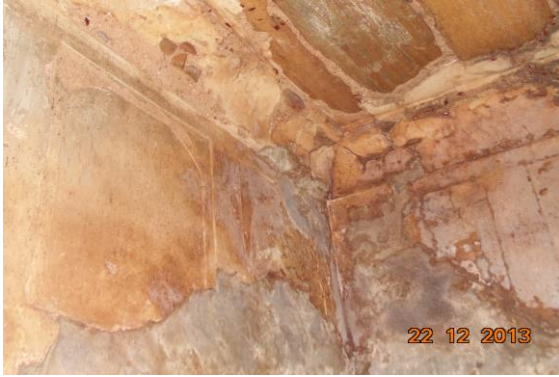
Photo 19

Peeling of Plaster & Damaged Portion All Walls of Hall No. 5, Part B of H. No.156 of Ground Floor

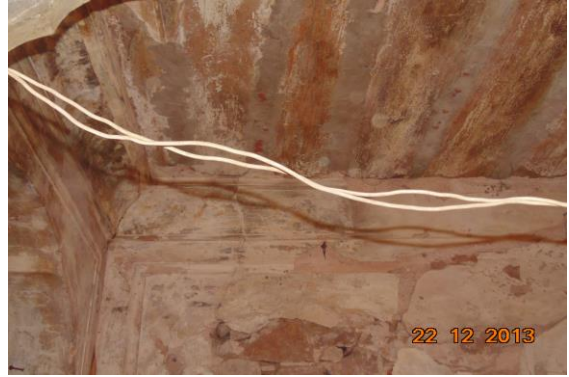
Photo 20

Peeling of Plaster & Damaged Portion All Walls of Hall No. 5, Part B of H. No.156 of Ground Floor

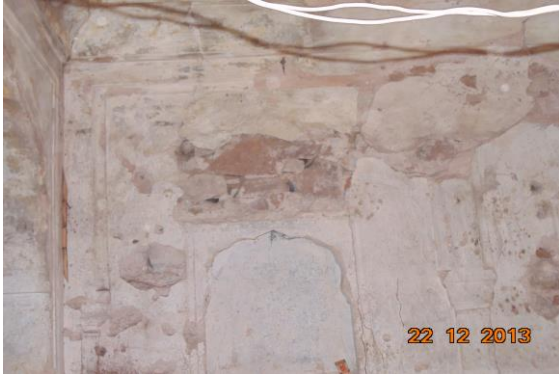
Photo 21

Peeling of Plaster & Damaged Portion All Walls of Hall No. 5, Part B of H. No.156 of Ground Floor

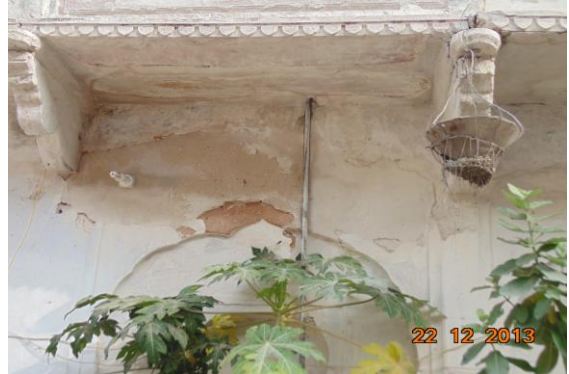
Photo 22

Peeling of Plaster on Wall No. 3 of Open Area Part B of Ground Floor

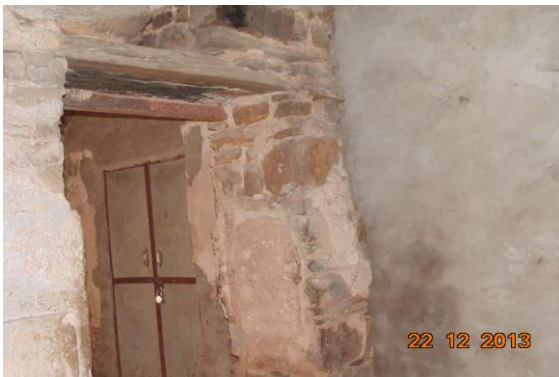
Photo 23

Dampness/Seepage on All Walls of Hall No. 2, Part B of H. No.156 of Ground Floor

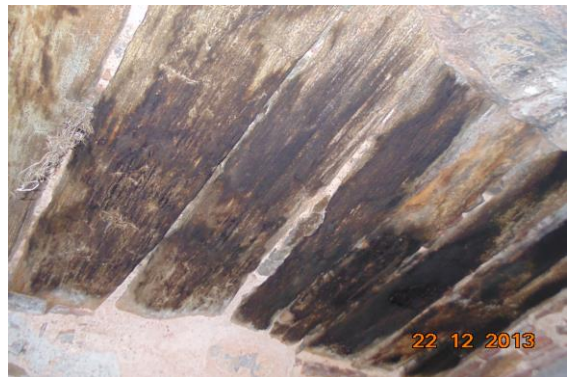
Photo 24

Dampness/Seepage on All Walls of Hall No. 2, Part B of H. No.156 of Ground Floor

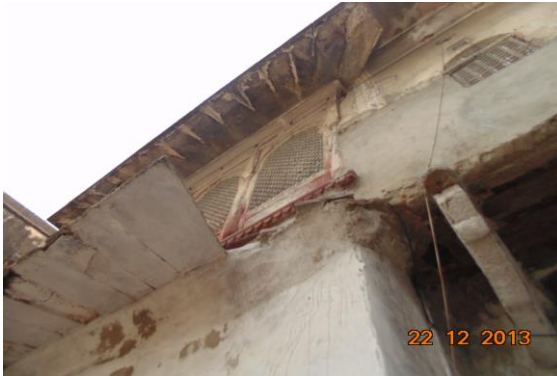
Photo 25

Peeling of Plaster & Damged Portion Roof Shade of Open Area Part B of Ground Floor

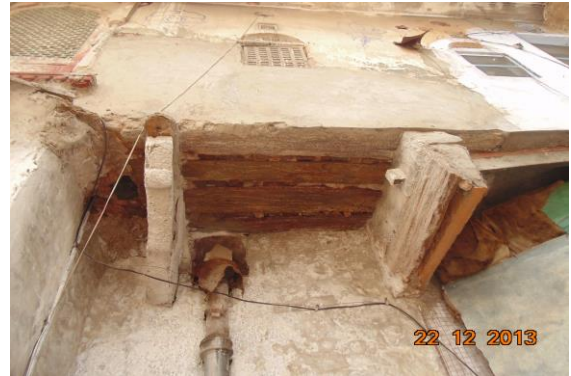
Photo 26

Peeling of Plaster & Damged Portion Roof Shade of Open Area Part B of Ground Floor
