Pre Building Condition Survey Report

Name and Address of Structure :	Choti Chopar to Badi Chopar (Down Line)
---------------------------------	---

Name of the Project	Contract JMRC-UG1B “Design and Construction of Tunnel between Chandpole and Badi Chouper and reverse line by Shield TBM, Underground Metro Stations at Choti Chouper and Badi Chouper by Cut and Cover Methods on East West Corridor of Jaipur Metro Rail Corporation Limited .”	
Owner :

Pre Building Condition Survey Report Choti Chopar to Badi Chopar (Down Line)

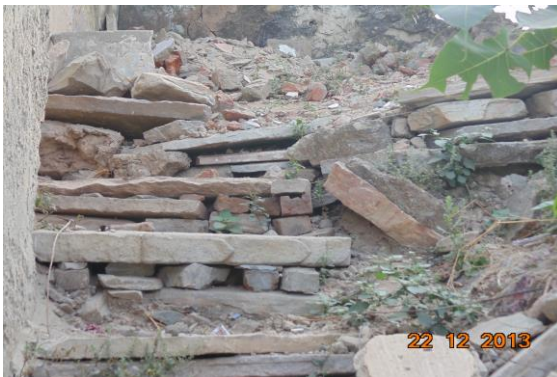
Photo 27

Peeling of Plaster on All walls Rear Portion of Hall No. 5 of Part A of H. no.156, Ground Floor

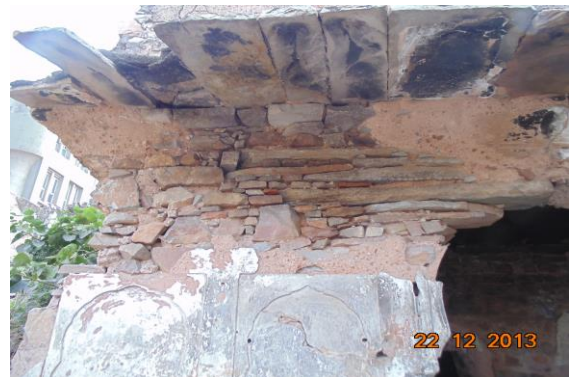
Photo 28

Peeling of Plaster & Damged Portion, Shade of Hall No. 5 of Part A of H. no.156, Ground Floor

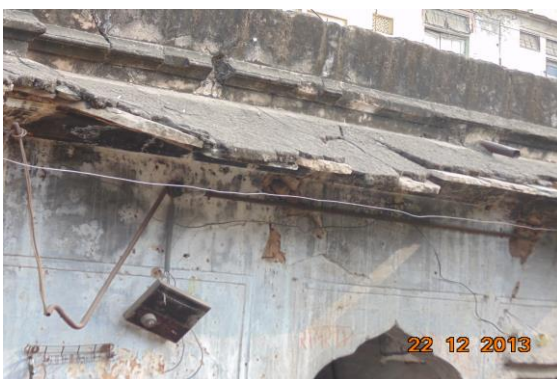
Photo 29

Peeling of Plaster on Wall No. 3 & D Shade, of Hall No. 5 of Part A of H. no.156, Ground Floor

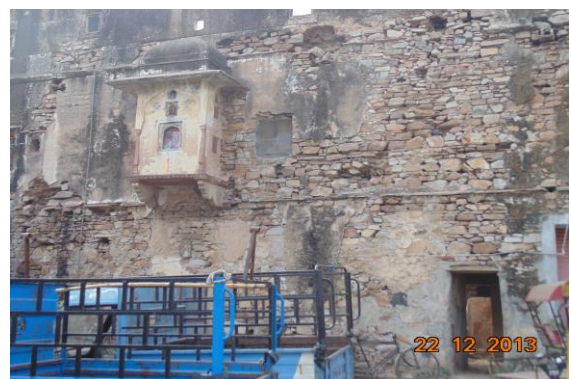
Photo 30

Peeling of Plaster on Wall No. 4 & Damaged Portion, of Hall No. 5 of Part A of H. no.156, Ground Floor

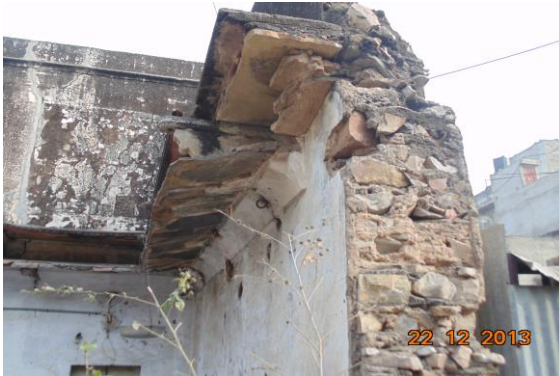
Photo 31

Peeling of Plaster on Damaged Portion, Shade of Hall No. 5 of Part A of H. no.156, Ground Floor

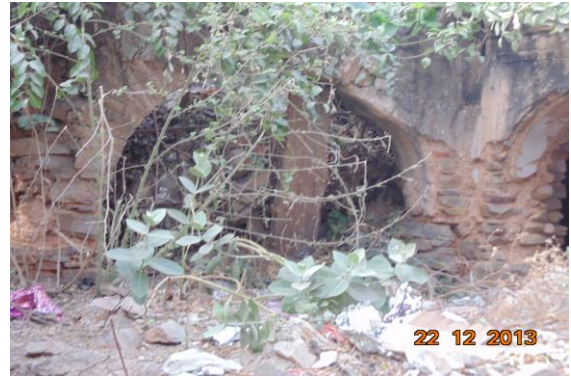
Photo 32

Peeling of Plaster on Damaged Portion, of Hall No. 3 of Part A of H. no.156, Ground Floor

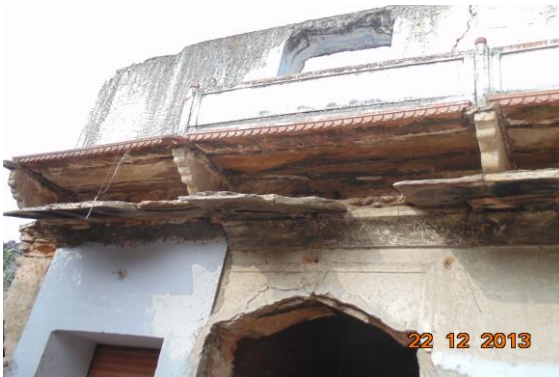
Photo 33

Peeling of Plaster on Roof Shade of Hall No. 3 of Part A of H. no.156, Ground Floor

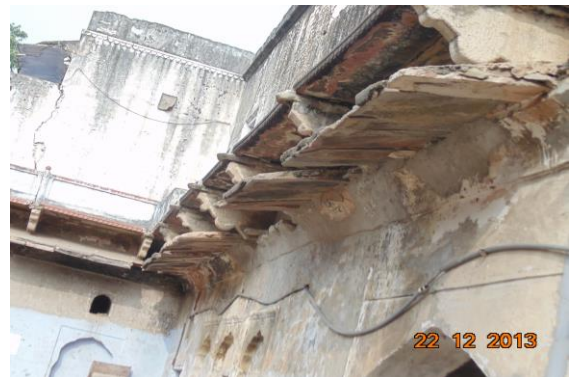
Photo 34

Peeling of Plaster on Roof Shade of Courtyard of H. No.156 of Part A of H. no.156, Ground Floor

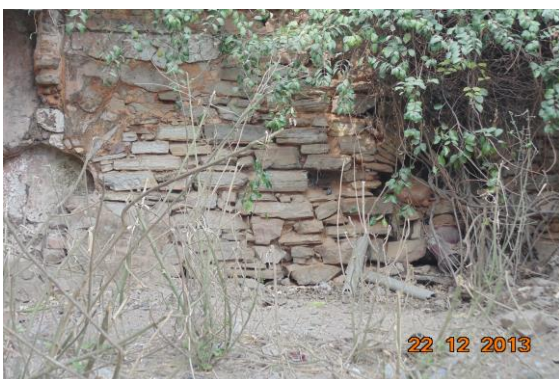
Photo 35

Peeling of Plaster on Wall No. 3 & Damaged Portion, of Hall No. 3 of Part A of H. no.156, Ground Floor

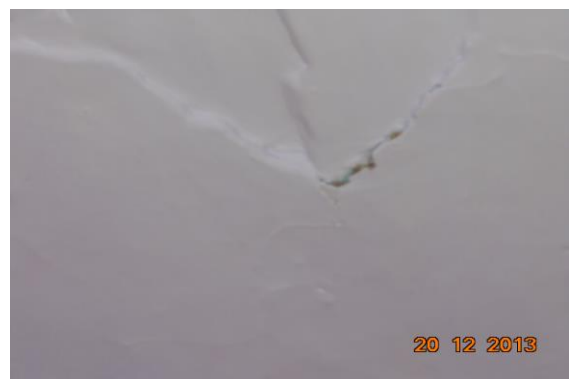
Photo 36

Peeling of Plaster on Roof of Shop No.1 of Ground Floor

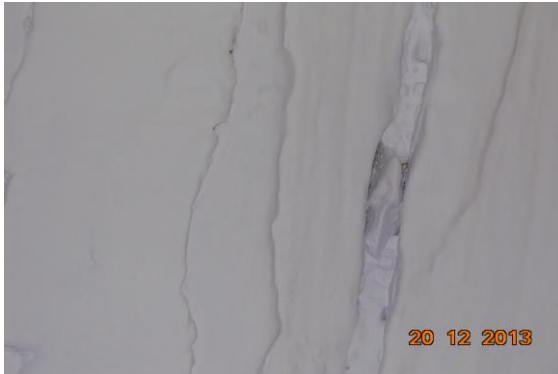
Photo 37
Damaged Portion on Roof of Shop No. 1 of Ground Floor

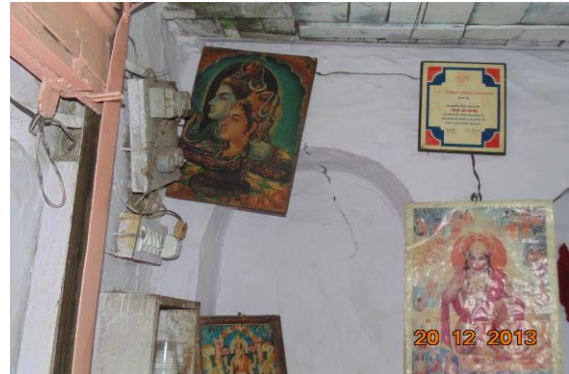
Photo 38
Peeling of Plaster on Wall No. 1 of Shop No. 1 of Ground Floor

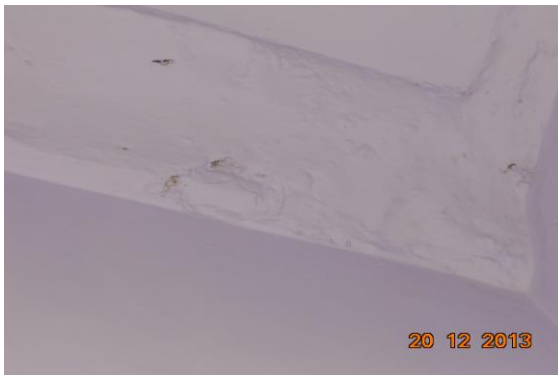
Photo 39
Peeling of Plaster on Roof of Shop No. 2 of Ground Floor

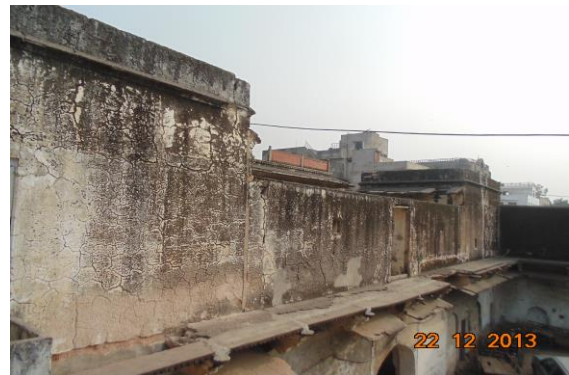
Photo 40
Damaged Portion on of Hall No. 1 of First Floor Part A

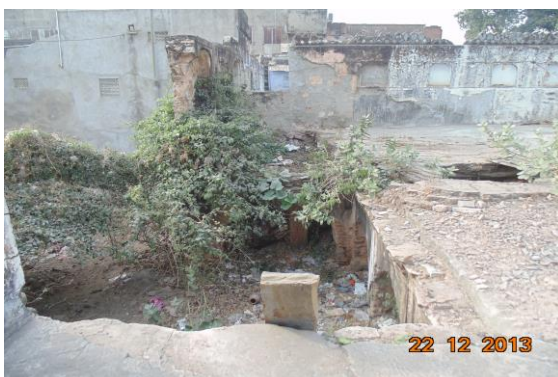
Photo 41
Damaged Portion on Floor of Open Area of First Floor Part A

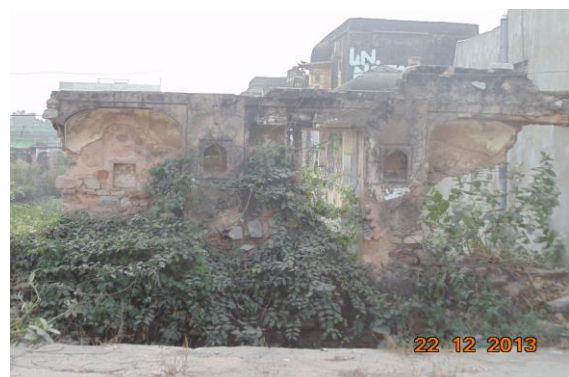
Photo 42
Damaged Portion on of Hall No. 2 of First Floor Part A

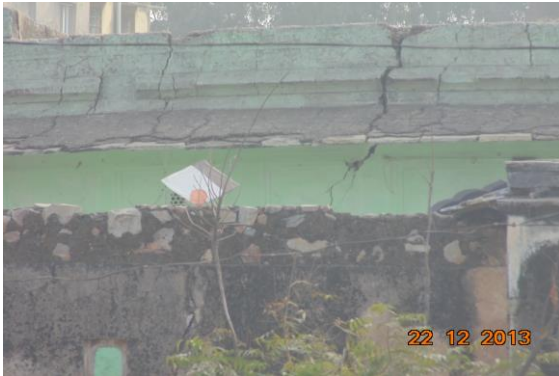
Photo 43
Damaged Portion on of Hall No. 3 of First Floor Part A

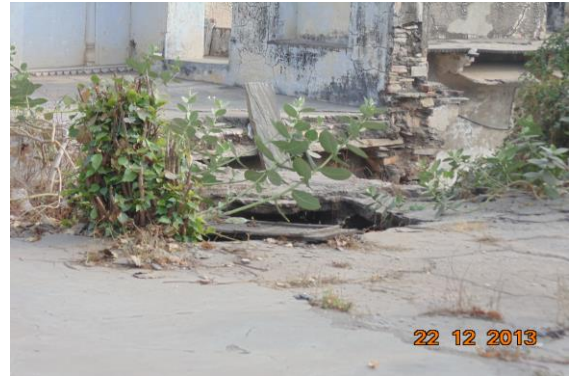
Photo 44
Damaged Portion on of Hall No. 3 of First Floor Part A

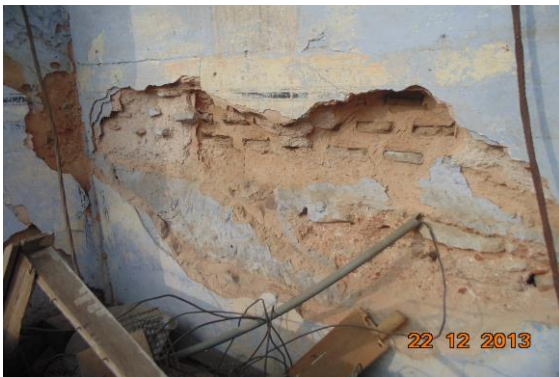
Photo 45
Damaged Portion on of Hall No. 2 of First Floor Part A

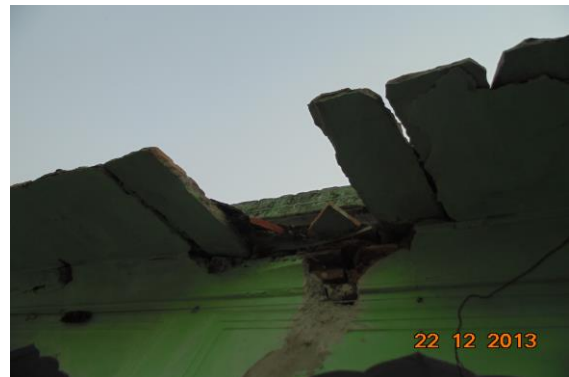
Photo 46
Damaged Portion on Roof of Hall No. 3 of First Floor Part A

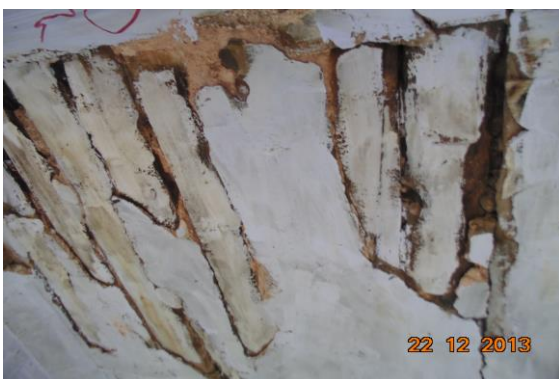
Photo 47
Damaged Portion on Roof of Hall No. 3 of First Floor Part A

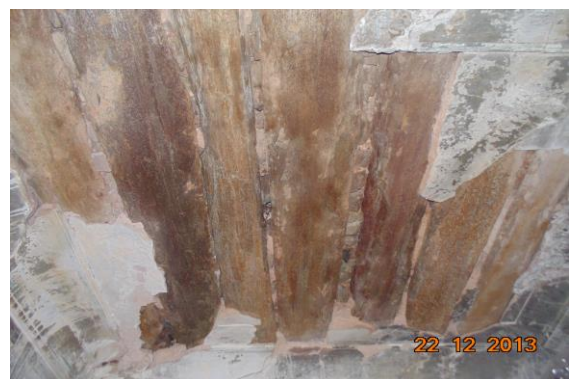
Photo 48
Damaged Portion on Roof of Hall No. 3 of First Floor Part A

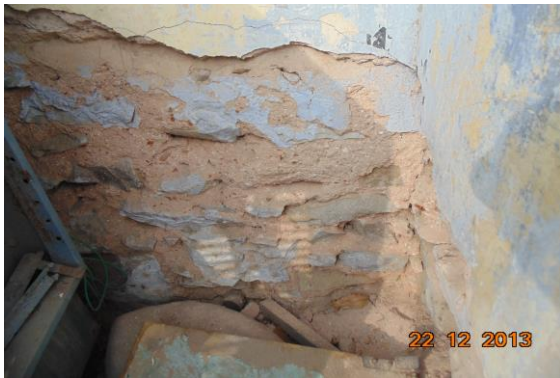
Photo 49
Damaged Portion on of Open Area of First Floor Part B

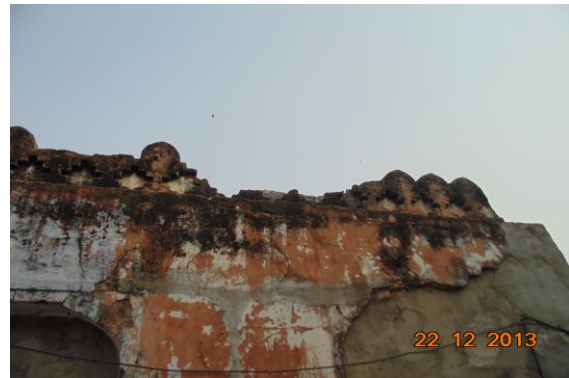
Photo 50
Damaged Portion on Open Area of First Floor Part B

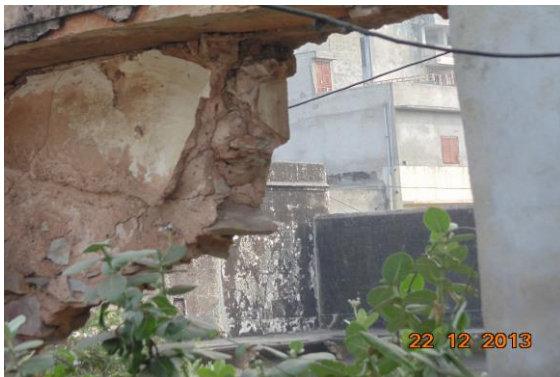
Photo 51
Damaged Portion on of Open Area of First Floor Part B

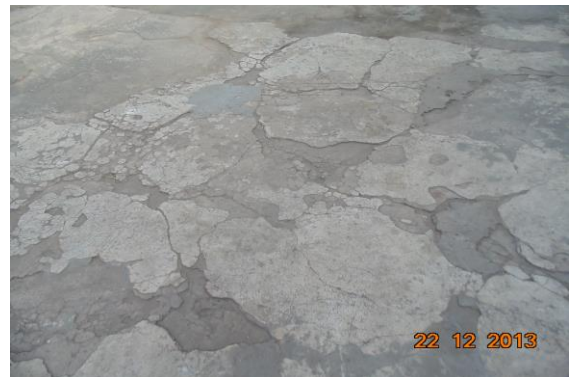
Photo 52
Damaged Portion on of Open Area of First Floor Part B

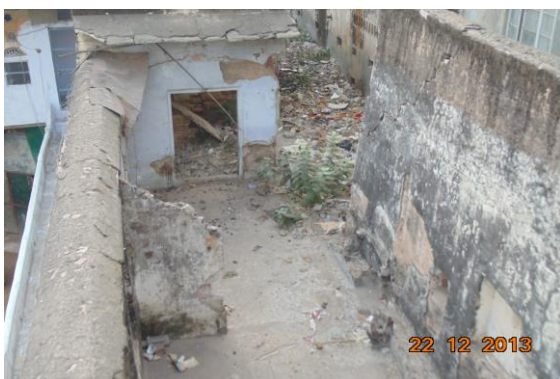
Photo 53
Peeling of Plaster on of Open Area of First Floor Part B

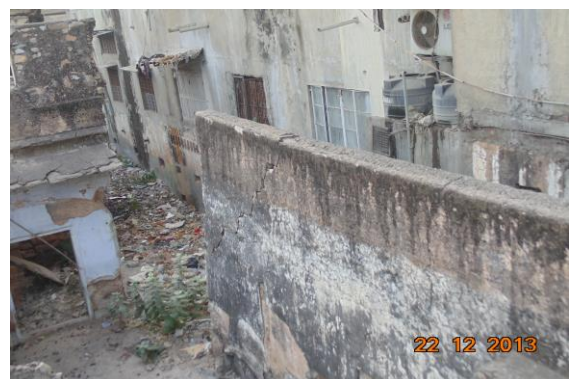
Photo 54
Damaged Portion on Floor of Hall No. 2 of First Floor Part B

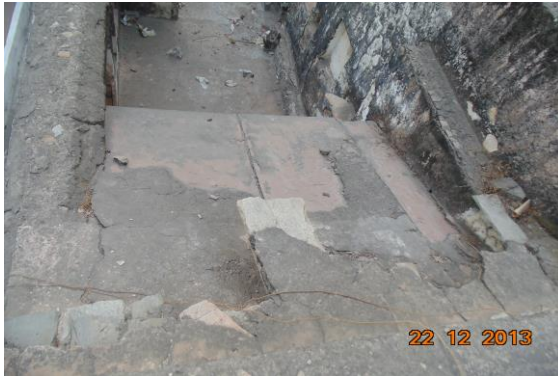
Photo 55
Damaged Portion on Hall No. 2 of First Floor Part B

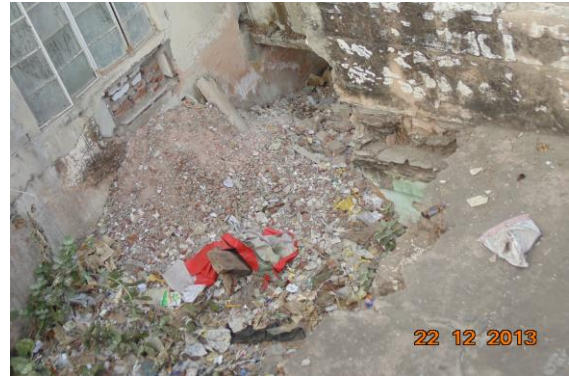
Photo 56
Damaged Portion on Roof of Hall No. 2 of First Floor Part B

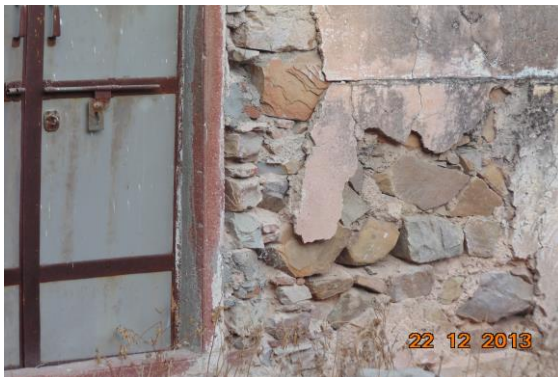
Photo 57
Damaged Portion on Gallery Wall of Gallery of First Floor Part C

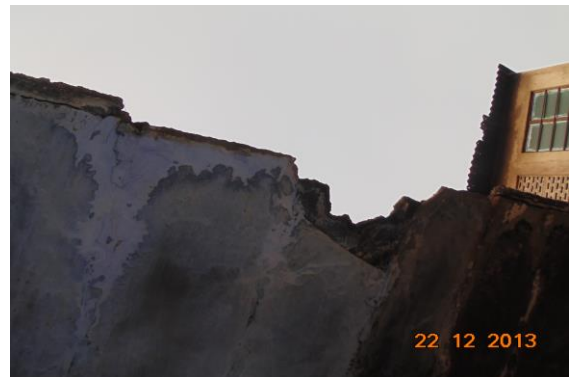
Photo 58
Damaged Portion on Roof of Shed of

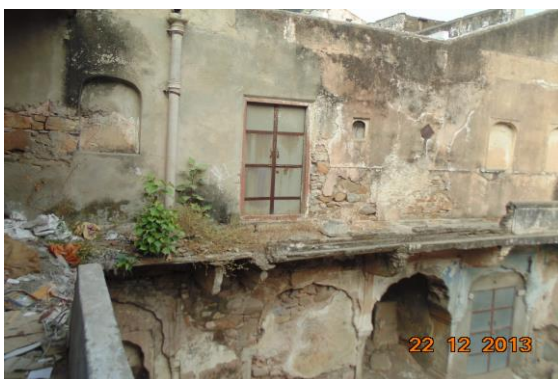
Photo 59
Damaged Portion on Parapet Wall of Gallery

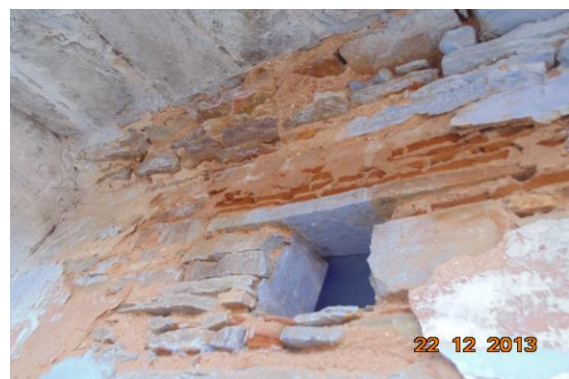
Photo 60
Damaged Portion on Shed of Gallery

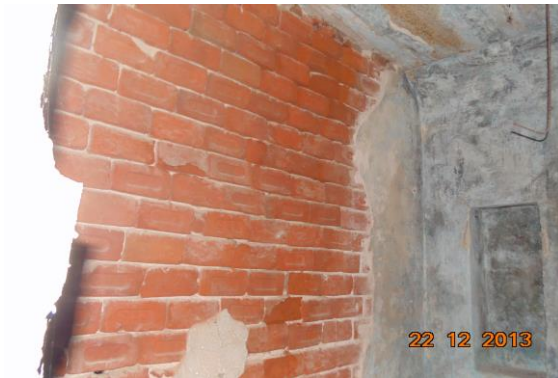
Photo 61
Damaged Portion on Hall No. 4 of

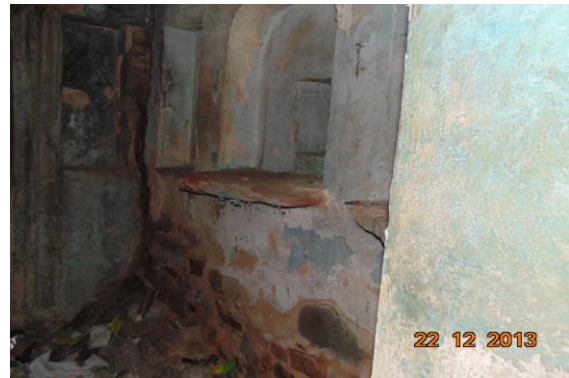
Photo 62
Damaged Portion on Hall No. 4 of

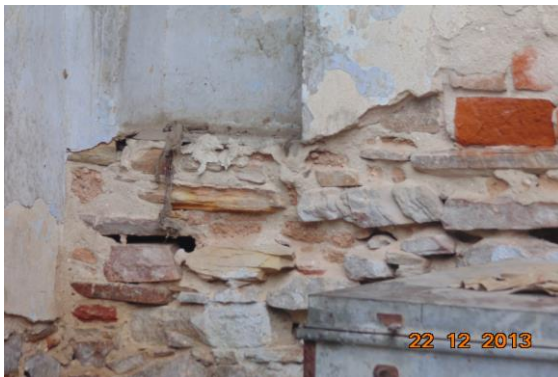
Photo 63
Damaged Portion on of Hall No. 4 of

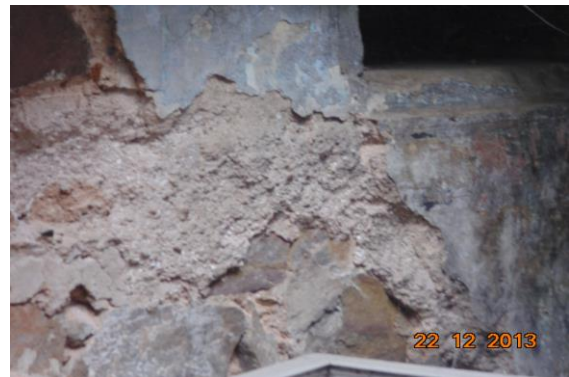
Photo 64
Damaged Portion on of Hall No. 4 of

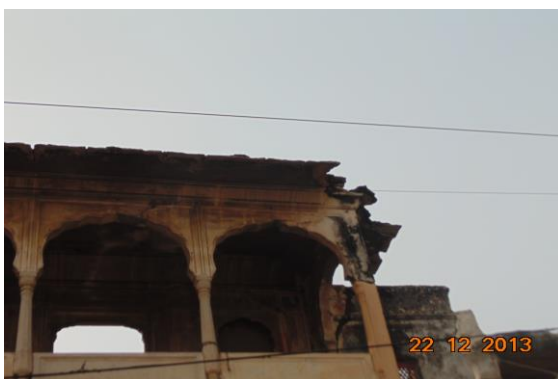
Photo 65
Damaged Portion on Front Side Wall of External Façade of Building.

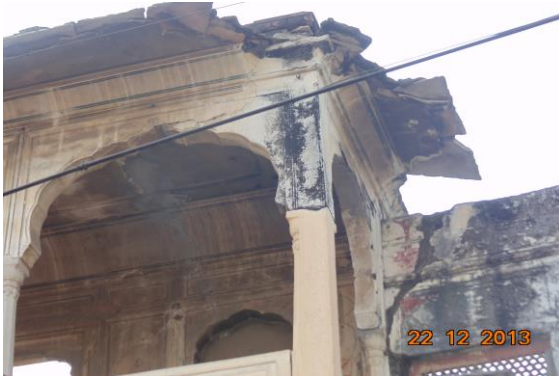
Photo 67

Damaged Portion on Front Side Wall of External Façade of Building

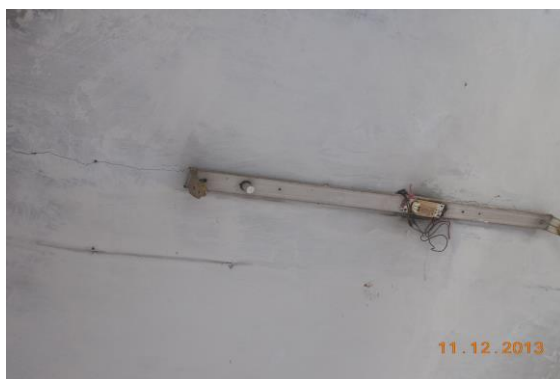
Summary of Cracks						
Defect ID	Location	Orientation	Appx. Width (mm)	Appx. Length (m)	Category	Photo No.
1	Roof Varanda of Shop No.315 Ground Floor	Inclined	0.8	3	Very Slight	11
2	Roof Varanda of Shop No.316 Ground Floor	Horizontal	1	3	Slight	12
3	Roof Varanda of Shop No.316 Ground Floor	Inclined	0.15	1.5	Very Slight	13
4	Roof Varanda of Shop No.317 Ground Floor	Horizontal	1	3	Slight	14
5	Roof Part A of Shop No.317 Ground Floor	Inclined	0.3	2	Very Slight	15
6	Roof Varanda of Shop No.318 Ground Floor	Inclined	0.35	1.5	Very Slight	16
7	Roof Varanda of Shop No.318 Ground Floor	Horizontal	0.2	3	Very Slight	17

Photo 11
Inclined Crack on Roof of Varanda of Shop No.315, Ground Floor
Approx. Width = 0.8mm, Approx. Length = 3m.
Distance from Left External Column = 0m, Height from Floor = 3m.

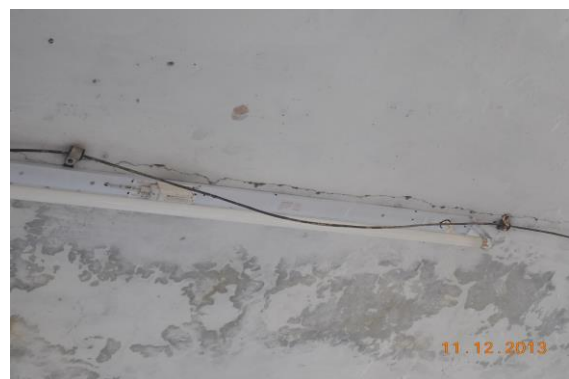
Photo 12
Horizontal Crack on Roof of Varanda of Shop No.316, Ground Floor
Approx. Width = 1mm, Approx. Length = 3m. Distance from Left External Column = 0m, Height from Floor = 3m.

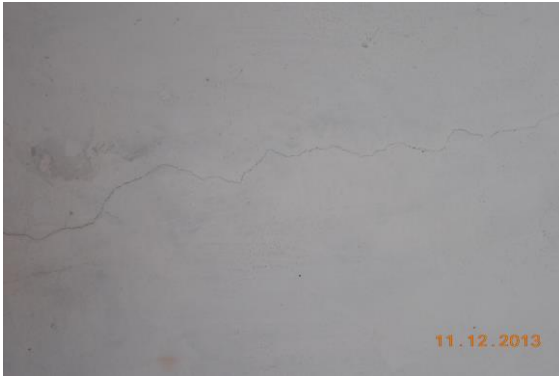
Photo 13

Inclined Crack on Roof of Varanda of Shop No.316, Ground Floor
Approx. Width = 0.15mm, Approx. Length = 1.5m. Distance from
Rightside External Column = 1.4m, Height from Floor = 3m.

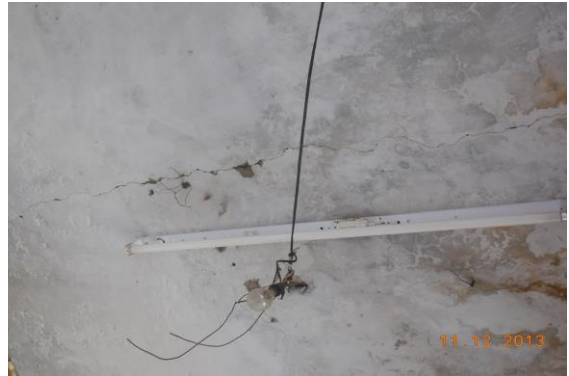
Photo 14

Horizontal Crack on Roof of Varanda of Shop No.317, Ground Floor
Approx. Width = 1mm, Approx. Length = 3m. Distance from Rightside
External Column = 0m, Height from Floor = 3m.

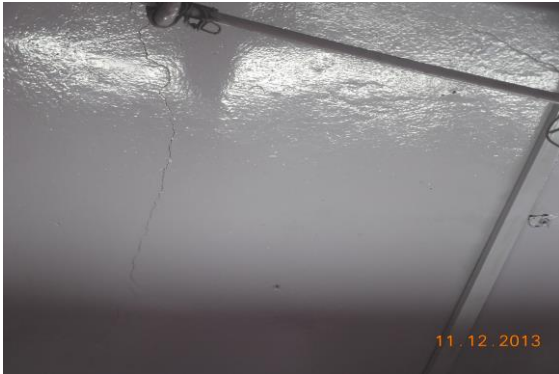
Photo 15

Inclined Crack on Roof of Part A of Shop No.317, Ground Floor
Approx. Width = 0.3mm, Approx. Length = 2m.
Distance from = m, Height from Floor = m.

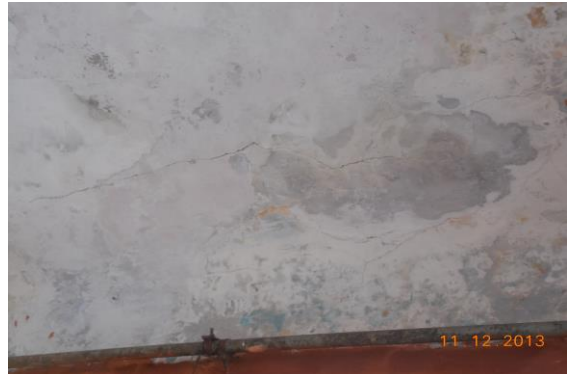
Photo 16

Inclined Crack on Roof of Varanda of Shop No.318, Ground Floor
Approx. Width = 0.35mm, Approx. Length = 1.5m. Distance from
Rightside External Column = 0m, Height from Floor = 3m.

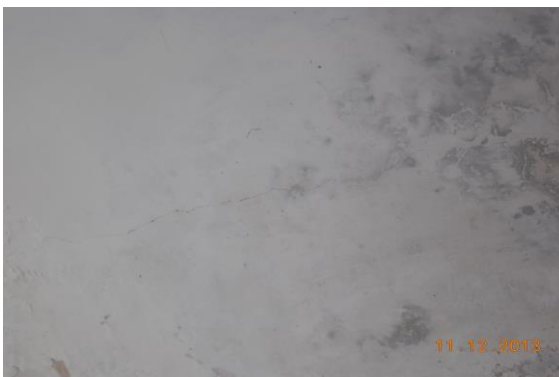
Photo 17

Horizontal Crack on Roof of Varanda of Shop No.318, Ground Floor
Approx. Width = 0.2mm, Approx. Length = 3m. Distance from Left
External Column = 0.9m, Height from Floor = 3m.

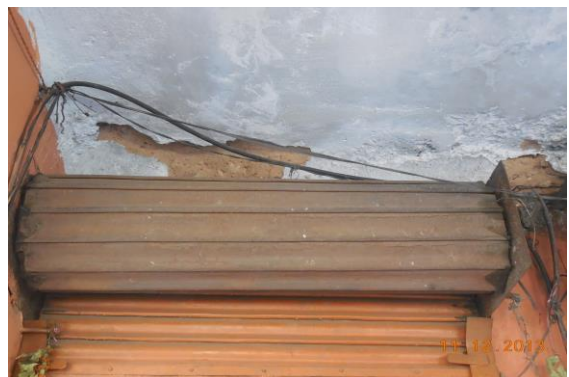
Photo 18

Summary of Defects Other Than Crack			
Defect ID	Location	Description	Photo No.
8	Roof Varanda of Shop No.313 Ground Floor	Peeling of Plaster	18
9	Roof Varanda of Shop No.313 Ground Floor	Dampness/Seepage	19
10	Roof Varanda of Shop No.313 Ground Floor	Dampness/Seepage	20
11	Rightside External Column Shop No.316 Ground Floor	Peeling of Plaster	21
12	Wall No. 1 Shop No.316 Ground Floor	Dampness/Seepage	22
13	Roof Shop No.316 Ground Floor	Peeling of Plaster	23
14	Roof Shop No.316 Ground Floor	Peeling of Plaster	24
15	LeftSide External Column Varanda of Shop No.317 Ground Floor	Peeling of Plaster	25
16	Roof Varanda of Shop No.317 Ground Floor	Dampness/Seepage	26
17	Roof Varanda of Shop No.317 Ground Floor	Peeling of Plaster	27
18	Roof Part B of Shop No.317 Ground Floor	Plaster Crack	28
19	Floor Part C of Shop No.317 Ground Floor	Peeling of Plaster	29
20	Rightside External Column Varanda of Shop No.318 Ground Floor	Damaged Portion	30

Peeling of Plaster on Roof of Varanda of Shop No.313 of Ground Floor

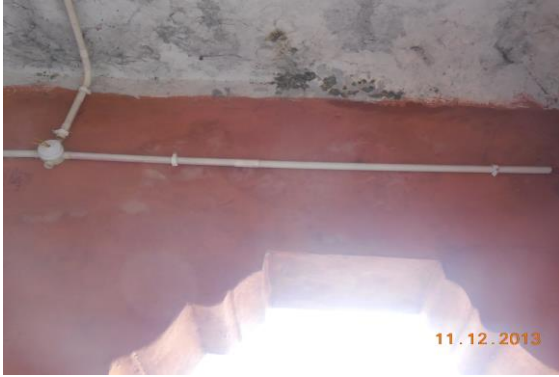
Photo 19

Dampness/Seepage on Roof of Varanda of Shop No.313 of Ground Floor

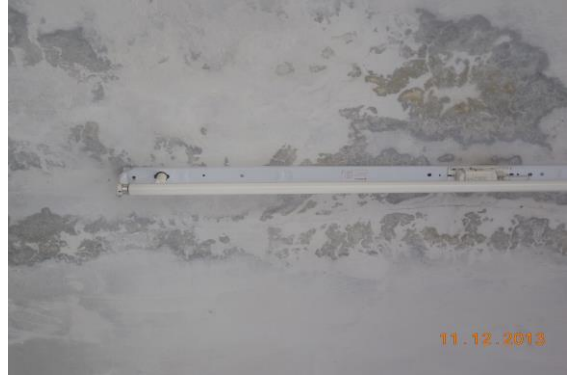
Photo 20

Dampness/Seepage on Roof of Varanda of Shop No.313 of Ground Floor

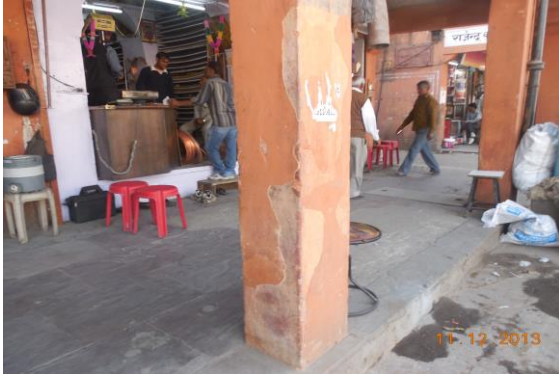
Photo 21

Peeling of Plaster on Rightside External Column of Shop No.316 of Ground Floor

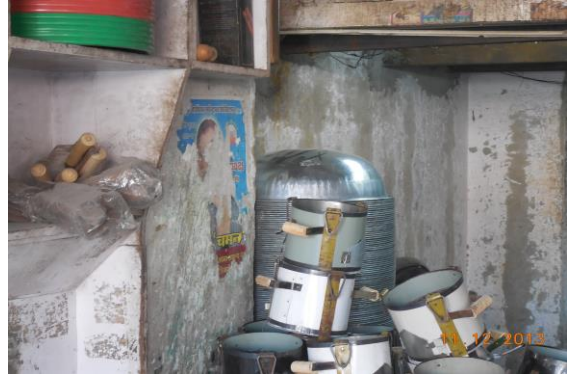
Photo 22

Dampness/Seepage on Wall No. 1 of Shop No.316 of Ground Floor

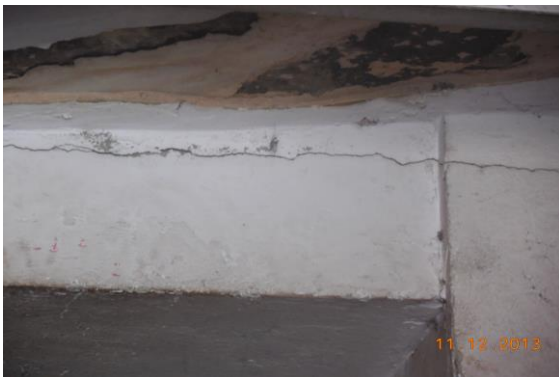
Photo 23

Peeling of Plaster on Roof of Shop No.316 of Ground Floor

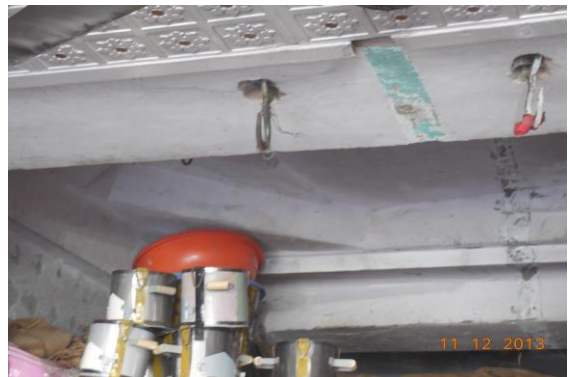
Photo 24

Peeling of Plaster on Roof of Shop No.316 of Ground Floor

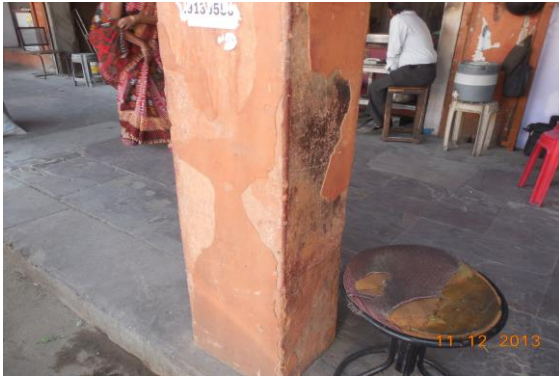
Photo 25

Peeling of Plaster on Left Side External Column of Varanda of Shop No.317 of Ground Floor

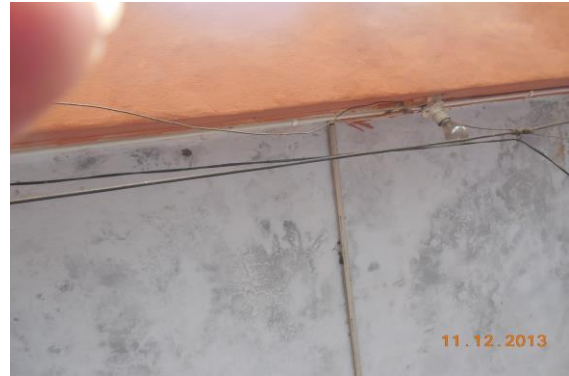
Photo 26

Dampness/Seepage on Roof of Varanda of Shop No.317 of Ground Floor

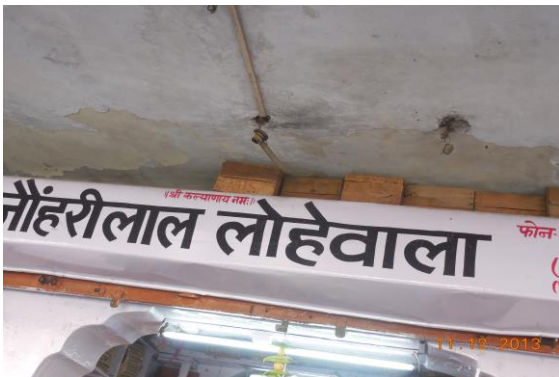
Photo 27

Peeling of Plaster on Roof of Varanda of Shop No.317 of Ground Floor

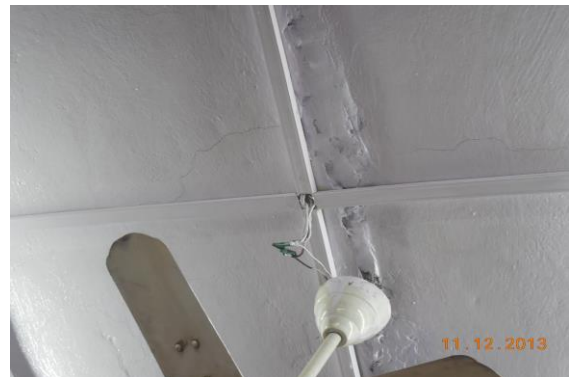
Photo 28

Plaster Crack on Roof of Part B of Shop No.317 of Ground Floor

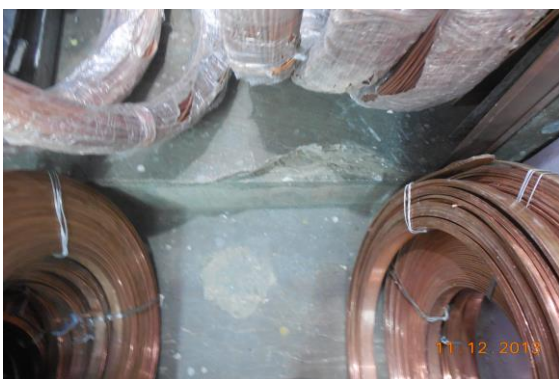
Photo 29

Peeling of Plaster on Floor of Part C of Shop No.317 of Ground Floor

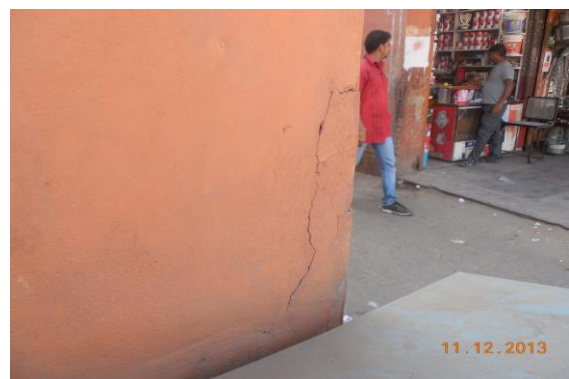
Photo 30

Damaged Portion on Rightside External Column of Varanda of Shop No.318 of Ground Floor

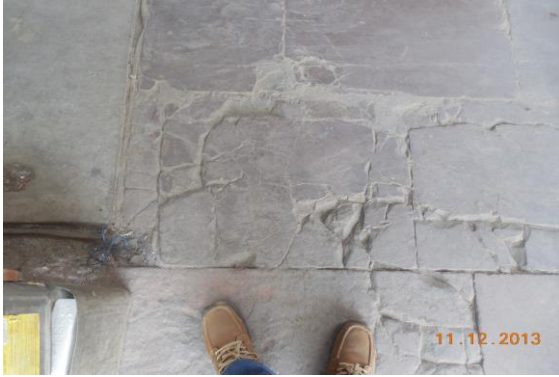
Photo 31

21	Floor Varanda of Shop No.318 Ground Floor	Damaged Portion	31
22	Roof Varanda of Shop No.318 Ground Floor	Dampness/Seepage	32
23	Roof Shop No.318 Ground Floor	Dampness/Seepage	33

Damaged Portion on Floor of Varanda of Shop No.318 of Ground Floor

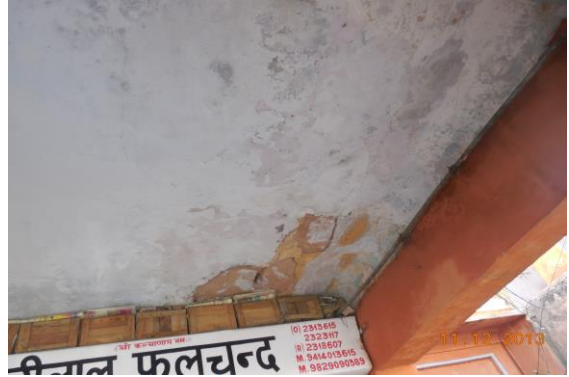
Photo 32

Dampness/Seepage on Roof of Varanda of Shop No.318 of Ground Floor

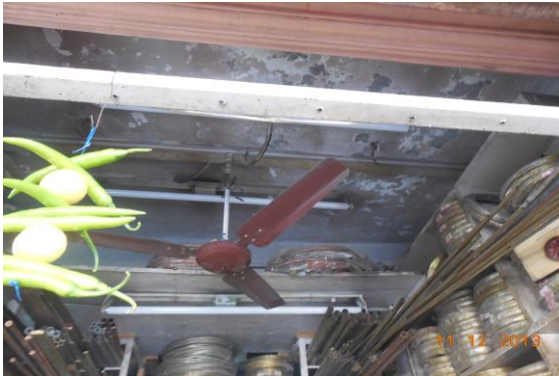
Photo 33

Dampness/Seepage on Roof of Shop No.318 of Ground Floor

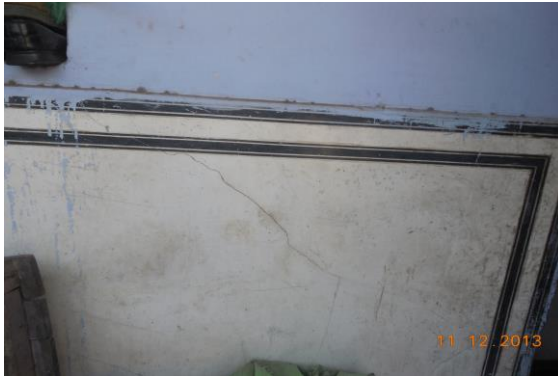
Photo 7

Inclined Crack on Wall No. 2 of Passage, First Floor
Approx. Width = 0.5mm, Approx. Length = 1.5m.
Distance from Wall No.3 = 1.1m, Height from Floor = 0.5m.

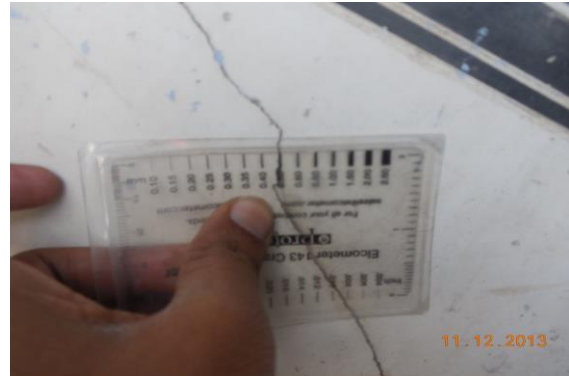
Photo 7A

Inclined Crack on Wall No. 2 of Passage, First Floor
Approx. Width = 0.5mm, Approx. Length = 1.5m.
Distance from Wall No.3 = 1.1m, Height from Floor = 0.5m.

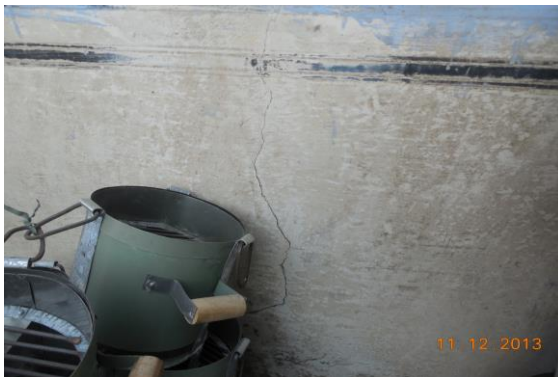
Photo 8

Inclined Crack on Wall No. 4 of Open sky, First Floor
Approx. Width = 0.6mm, Approx. Length = 1m.
Distance from Wall No.2 = 1.3m, Height from Floor = 0.1m.

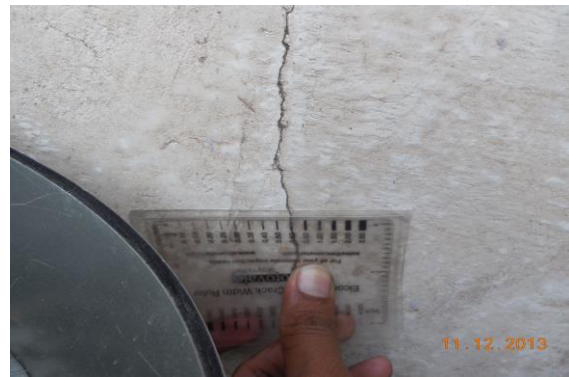
Photo 8A

Inclined Crack on Wall No. 4 of Open sky, First Floor
Approx. Width = 0.6mm, Approx. Length = 1m.
Distance from Wall No.2 = 1.3m, Height from Floor = 0.1m.

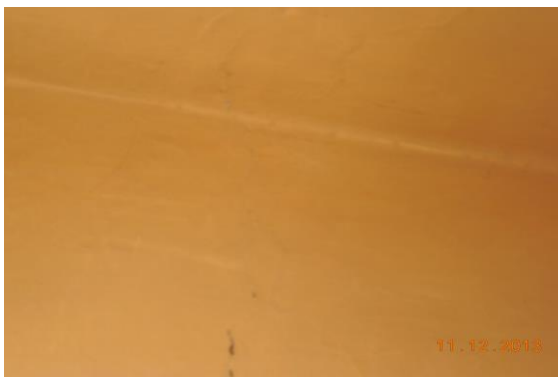
Photo 9

Inclined Crack on Wall No. 2 & Roof of Passage No.4, First Floor
Approx. Width = 2.5mm, Approx. Length = 1.7m.
Distance from Wall No.4 = 0.15m, Height from Floor = 1m.

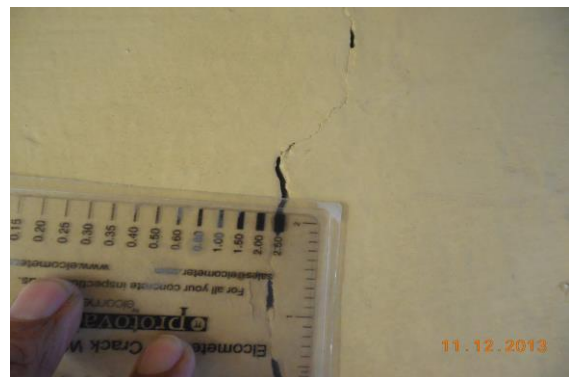
Photo 9A

Inclined Crack on Wall No. 2 & Roof of Passage No.4, First Floor
Approx. Width = 2.5mm, Approx. Length = 1.7m.
Distance from Wall No.4 = 0.15m, Height from Floor = 1m.

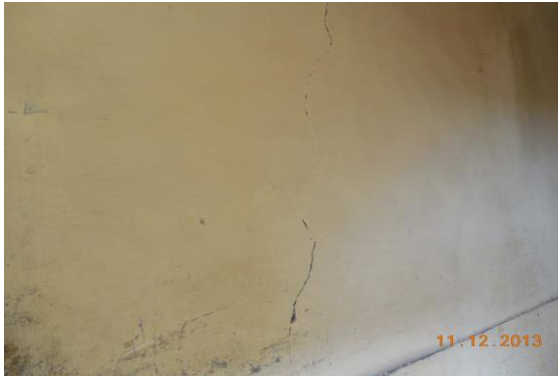
Photo 10

Inclined Crack on Wall No. 3 of Passage No.5, First Floor
Approx. Width = 1mm, Approx. Length = 1m.
Distance from Wall No.2 = 3.5m, Height from Floor = 0.7m.

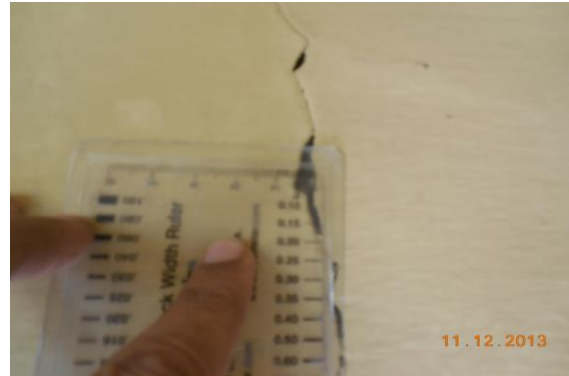
Photo 10A

Inclined Crack on Wall No. 3 of Passage No.5, First Floor
Approx. Width = 1mm, Approx. Length = 1m.
Distance from Wall No.2 = 3.5m, Height from Floor = 0.7m.

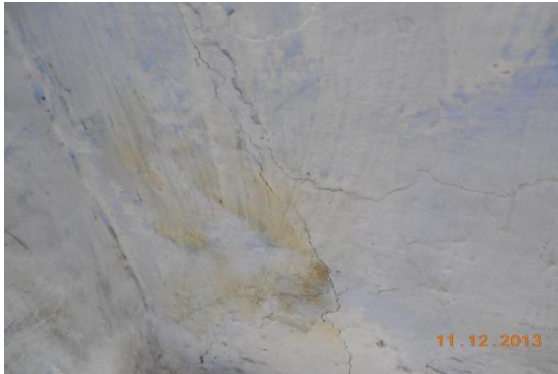
Photo 11

Inclined Crack on Roof of Gate , Ground Floor
Approx. Width = 0.8mm, Approx. Length = 0.8m.
Distance from Wall No.1 = 0m, Height from Floor = 2m.

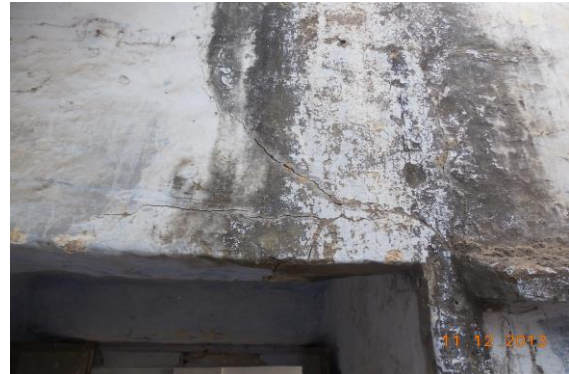
Photo 12

Inclined Crack on Wall No. 3 of Open Sky, First Floor
Approx. Width = 2mm, Approx. Length = 0.7m.
Distance from Wall No.2 = 1m, Height from Floor = 2m.

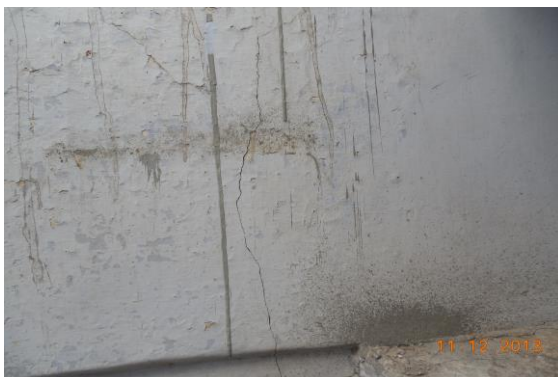
Photo 13

Inclined Crack on Wall No. 1 of Open Sky, First Floor
Approx. Width = 1.5mm, Approx. Length = 2m.
Distance from Wall No.4 = 0.6m, Height from Floor = 0.4m.

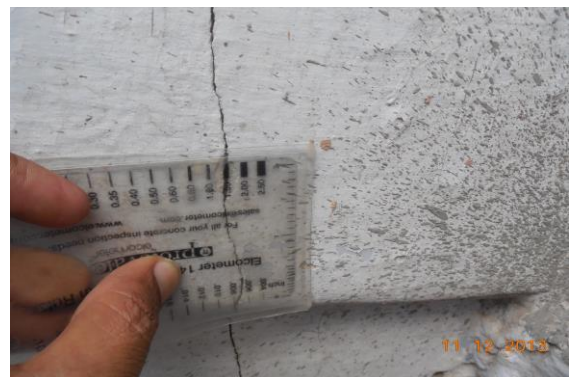
Photo 13A

Inclined Crack on Wall No. 1 of Open Sky, First Floor
Approx. Width = 1.5mm, Approx. Length = 2m.
Distance from Wall No.4 = 0.6m, Height from Floor = 0.4m.

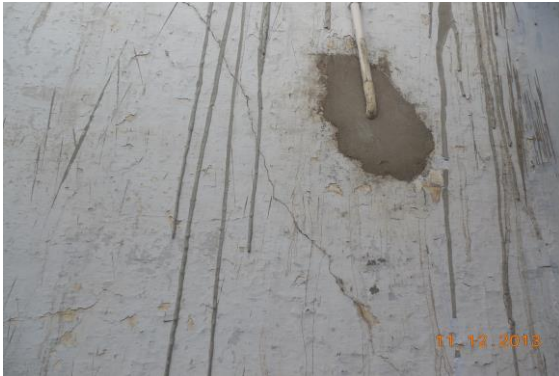
Photo 14

Inclined Crack on Wall No. 1 of Open Sky, First Floor
Approx. Width = 0.6mm, Approx. Length = 2.5m.
Distance from Wall No.4 = 1.6m, Height from Floor = 1.6m.

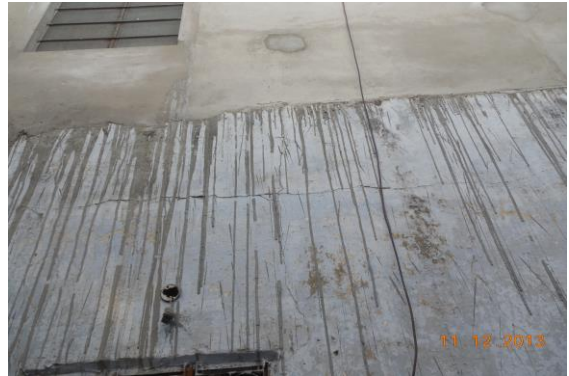
Photo 15

Horizontal Crack on Wall No. 1 of Open Sky, First Floor
Approx. Width = 0.6mm, Approx. Length = 4.5m.
Distance from = m, Height from Floor = 3m.

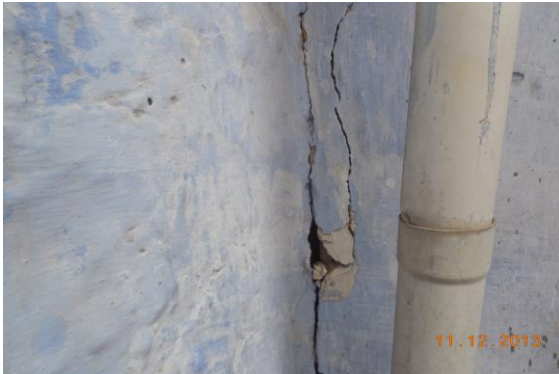
Photo 16

Inclined Crack on Wall No. 2 of Open sky, First Floor
Approx. Width = 2.5mm, Approx. Length = 1m.
Distance from Wall No.4 = 0m, Height from Floor = 0.4m.

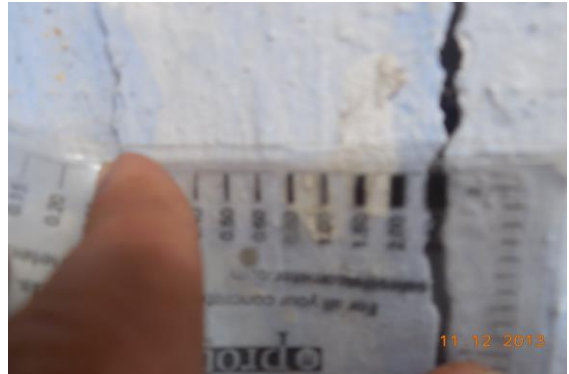
Photo 16A

Inclined Crack on Wall No. 2 of Open sky, First Floor
Approx. Width = 2.5mm, Approx. Length = 1m.
Distance from Wall No.4 = 0m, Height from Floor = 0.4m.

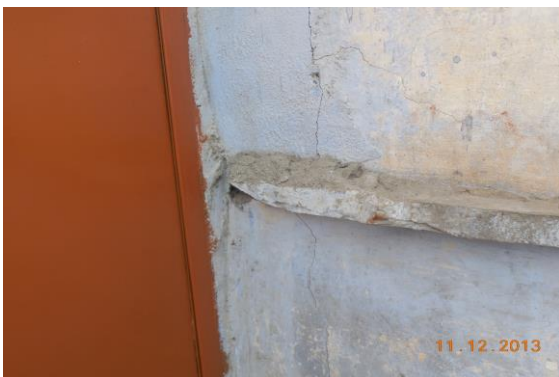
Photo 17

Vertical Crack on Wall No. 1 of Passage, Second Floor
Approx. Width = 0.6mm, Approx. Length = 0.6m.
Distance from Wall No.3 = 0.15m, Height from Floor = 0m.

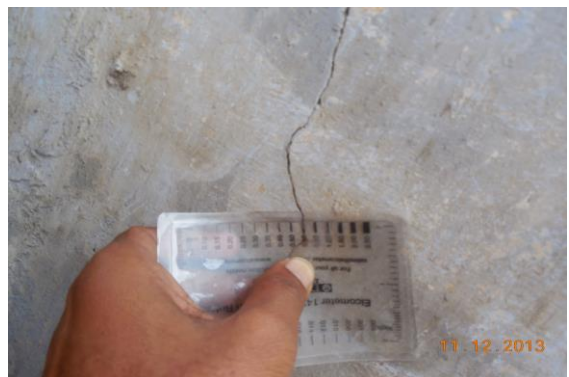
Photo 17A

Vertical Crack on Wall No. 1 of Passage, Second Floor
Approx. Width = 0.6mm, Approx. Length = 0.6m.
Distance from Wall No.3 = 0.15m, Height from Floor = 0m.

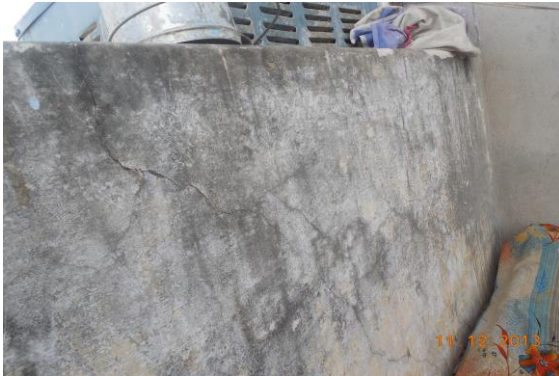
Photo 18

Inclined Crack on Wall No. 1 of Passage, Second Floor
Approx. Width = 0.25mm, Approx. Length = 1.1m.
Distance from Wall No.4 = 0.5m, Height from Floor = 0.8m.

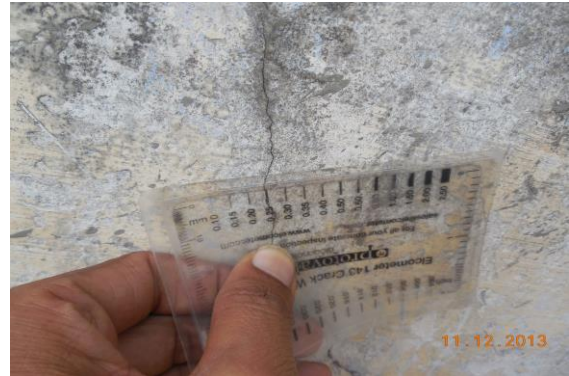
Photo 18A

Inclined Crack on Wall No. 1 of Passage, Second Floor
Approx. Width = 0.25mm, Approx. Length = 1.1m.
Distance from Wall No.4 = 0.5m, Height from Floor = 0.8m.

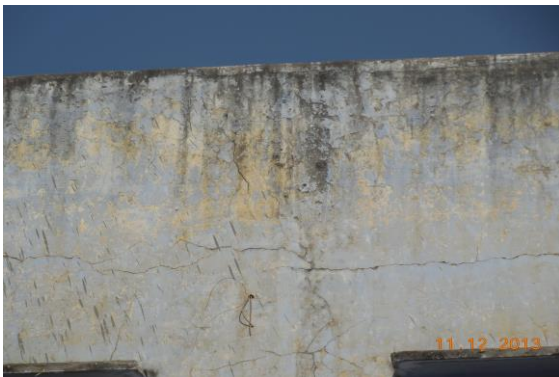
Photo 19

Horizontal Crack on Wall No. Outerwall of , Second Floor
Approx. Width = 0.8mm, Approx. Length = 3.5m.
Distance from Wall No.1 = 0m, Height from Floor = 6m.

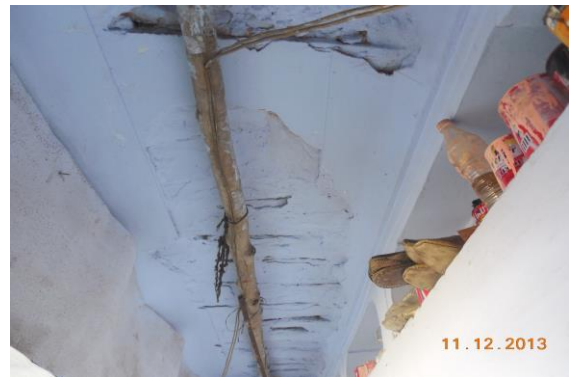
Photo 20

Peeling of Plaster on Roof of Passage of First Floor

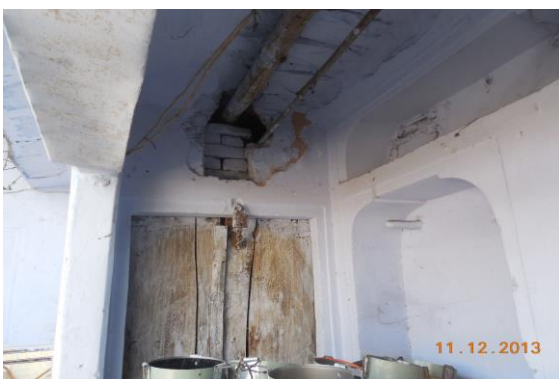
Photo 21

Peeling of Plaster on Wall No. 4 of Passage of First Floor

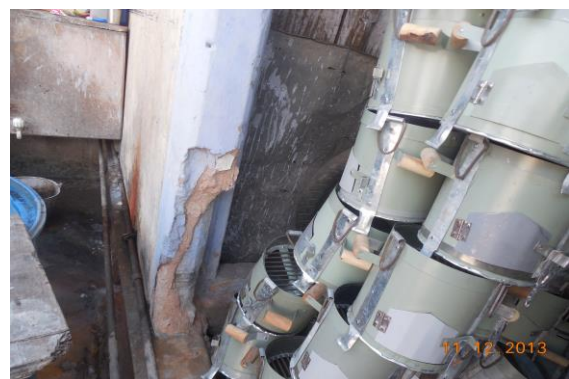
Photo 22

Damaged Portion on Wall No. 4 of Passage of First Floor

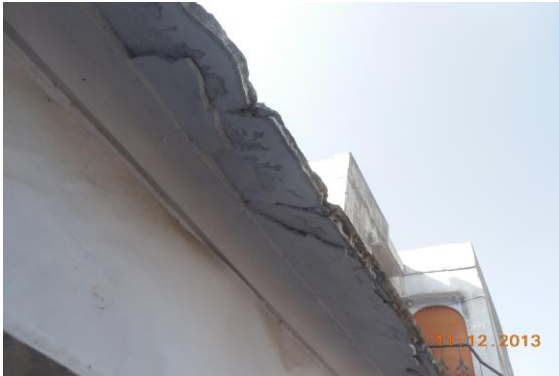
Photo 23

Damaged Portion on Wall No. 3 & Shade of Open sky of First Floor

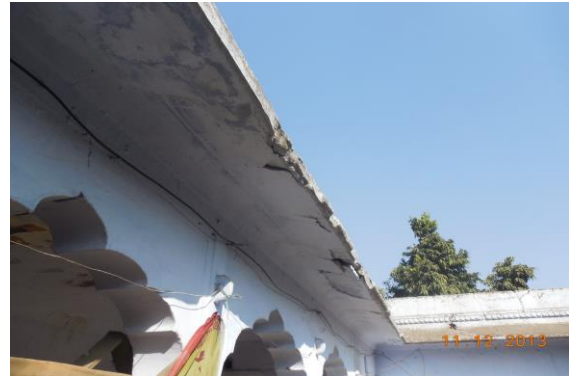
Photo 24

Damaged Portion on Wall No. 1 & Shade of Open sky of First Floor

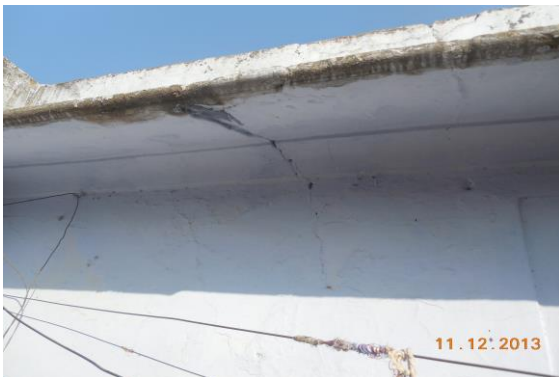
Photo 25

Damaged Portion on Wall No. 4 & Shade of Open sky of First Floor

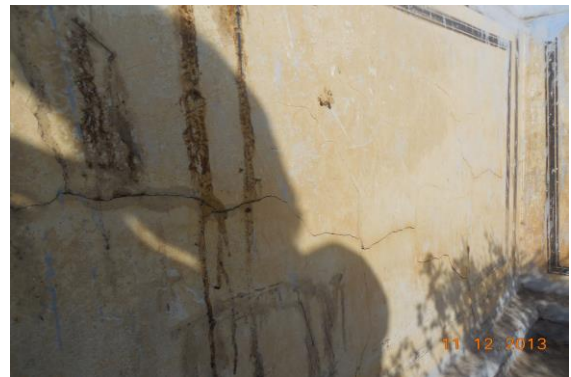
Photo 26

Plaster Crack on Wall No. 1 of Open sky of First Floor

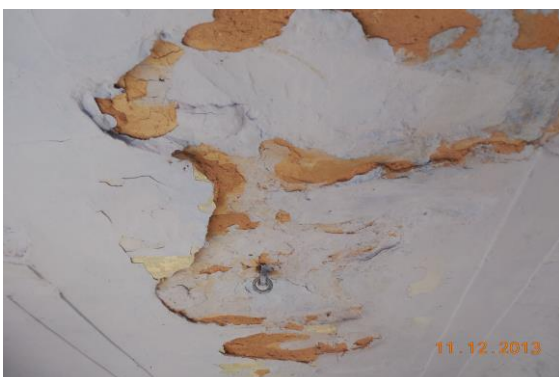
Photo 27

Peeling of Plaster on Roof of Varanda No.1 of First Floor

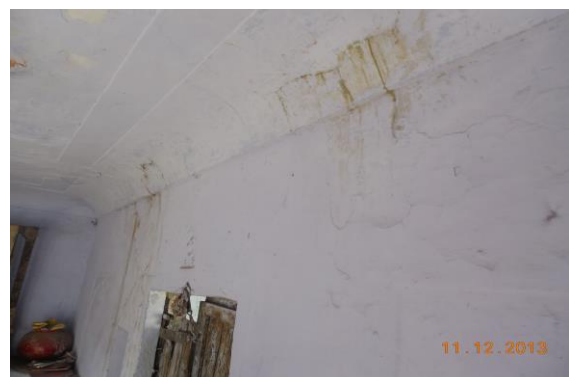
Photo 28

Dampness/Seepage on Wall No. 4 of Varanda No.1 of First Floor
