Pre Building Condition Survey Report

Name and Address of Structure :	Choti Chopar to Badi Chopar (Down Line)
---------------------------------	---

Name of the Project	Contract JMRC-UG1B “Design and Construction of Tunnel between Chandpole and Badi Chouper and reverse line by Shield TBM, Underground Metro Stations at Choti Chouper and Badi Chouper by Cut and Cover Methods on East West Corridor of Jaipur Metro Rail Corporation Limited .”	
Owner :

Pre Building Condition Survey Report Choti Chopar to Badi Chopar (Down Line)

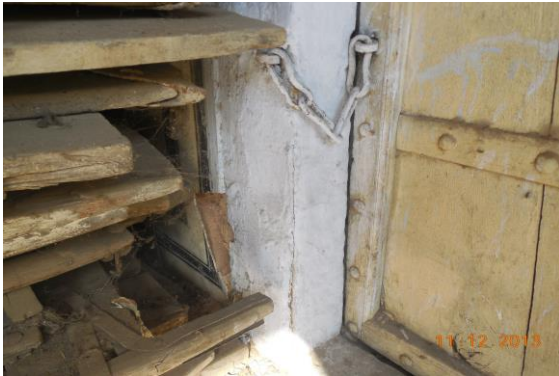
Photo 29
Damaged Portion on Wall No. 2 of Varanda No.1 of First Floor

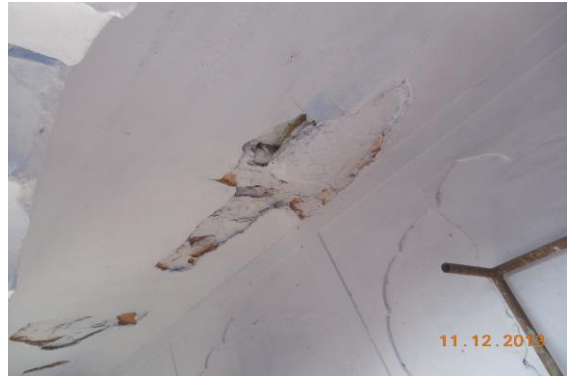
Photo 30
Damaged Portion on Balcony of First Floor

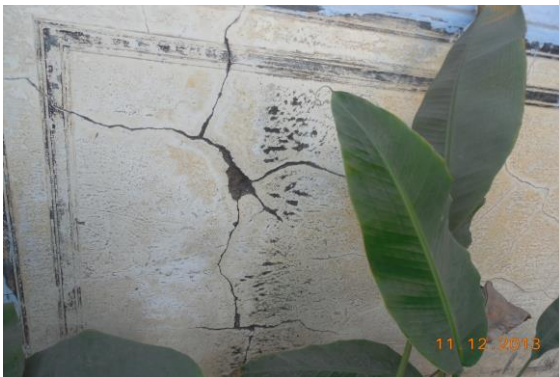
Photo 31
Damaged Portion on Wall No. 3 of Open sky of First Floor

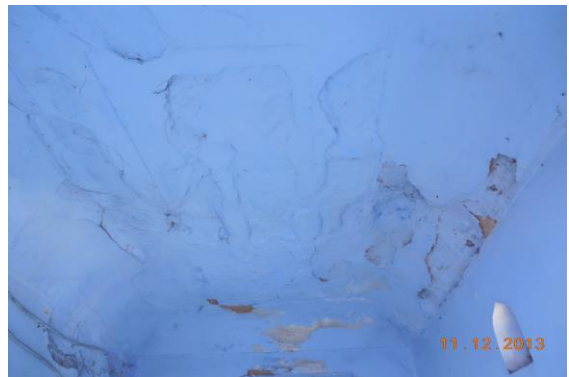
Photo 32
Peeling of Plaster on Roof of Passage No.2 of First Floor

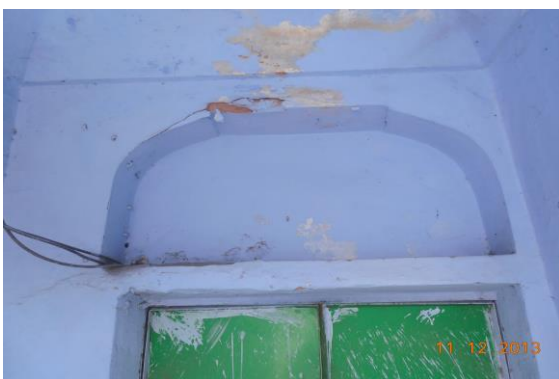
Photo 33
Peeling of Plaster on Wall No. 4 of Passage No.2 of First Floor

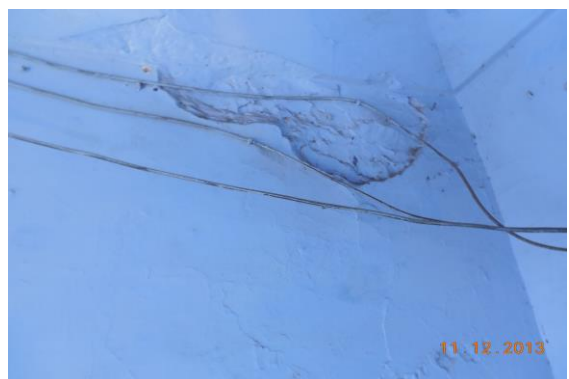
Photo 34
Peeling of Plaster on Wall No. 1 of Passage No.2 of First Floor

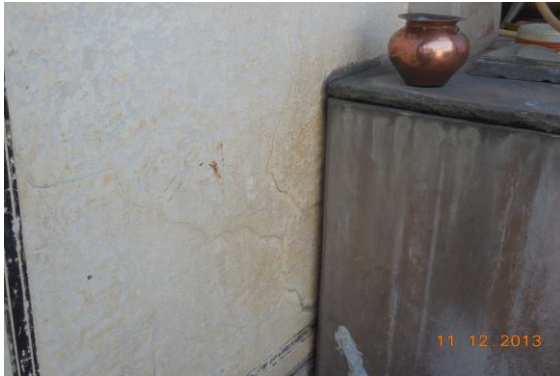
Photo 35

Peeling of Plaster on Wall No. 2 of Open sky of First Floor

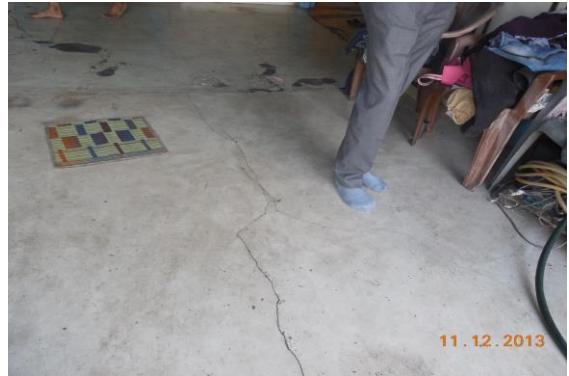
Photo 36

Plaster Crack on Wall No. Floor of Varanda No.2 of First Floor

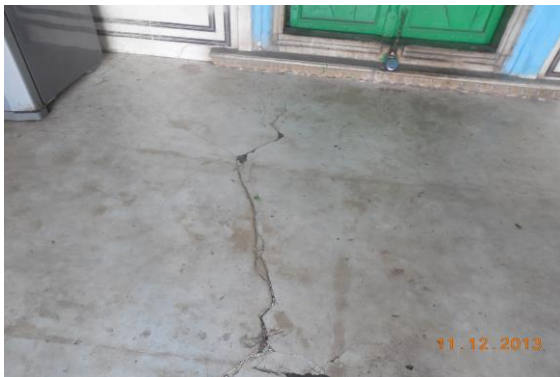
Photo 37

Plaster Crack on Wall No. Floor of Varanda No.2 of First Floor

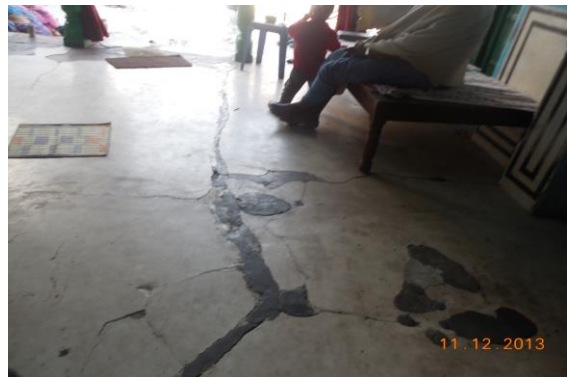
Photo 38

Peeling of Plaster on Wall No. Floor of Varanda No.2 of First Floor

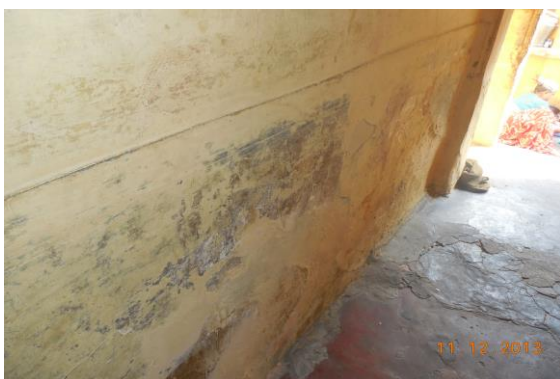
Photo 39

Peeling of Plaster on Wall No. 1 of Passage No.4 of First Floor

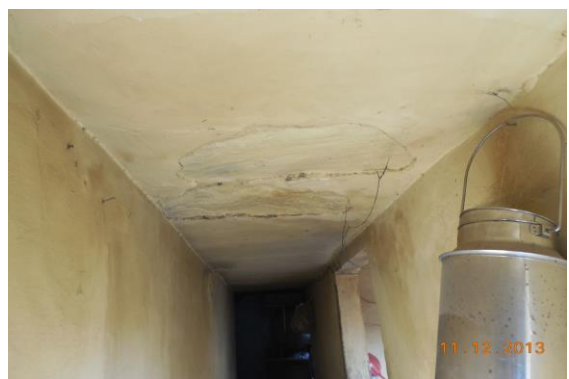
Photo 40

Peeling of Plaster on Roof of Passage No.5 of First Floor

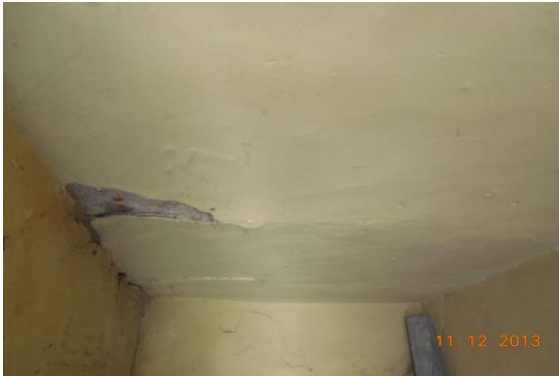
Photo 41
Peeling of Plaster on Roof of Passage No.5 of First Floor

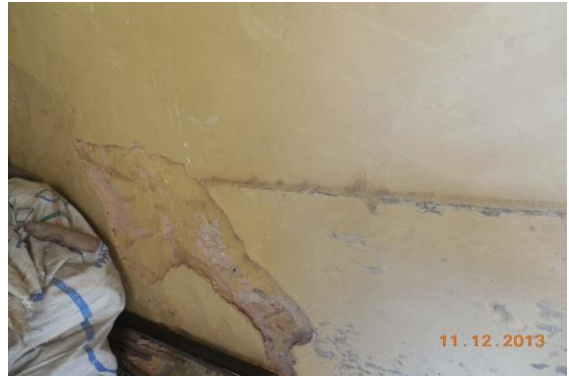
Photo 42
Peeling of Plaster on Wall No. 3 of Passage No.5 of First Floor

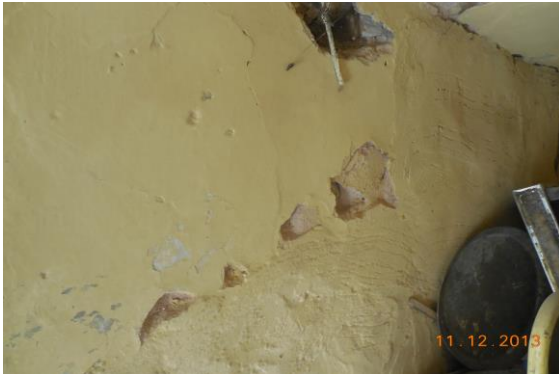
Photo 43
Peeling of Plaster on Wall No. 4 of Passage No.5 of First Floor

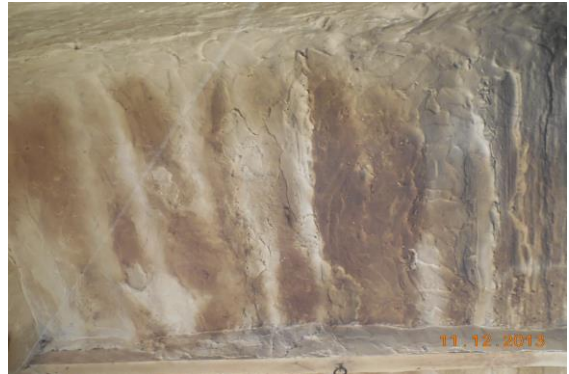
Photo 44
Dampness/Seepage on Roof of Kitchen of First Floor

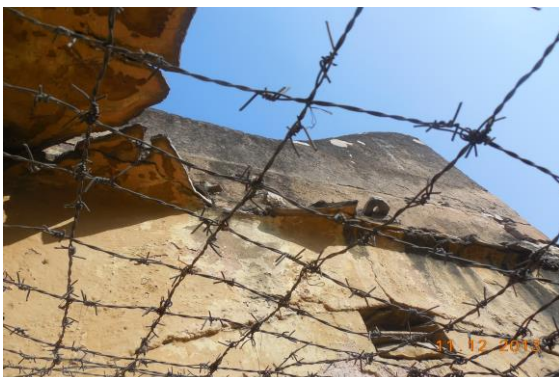
Photo 45
Damaged Portion on Wall No. 1 & Shade of Open Sky No.2 of First Floor

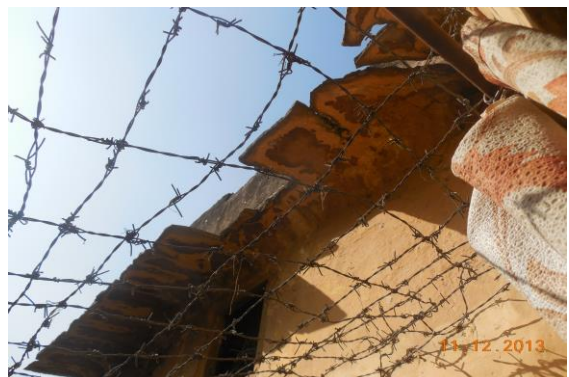
Photo 46
Damaged Portion on Wall No. 3 & Shade of Open Sky No.2 of First Floor

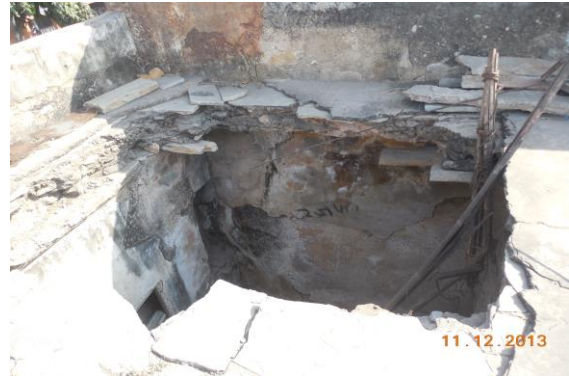
Photo 48
Dampness/Seepage on Roof of Room No. 7 of First Floor

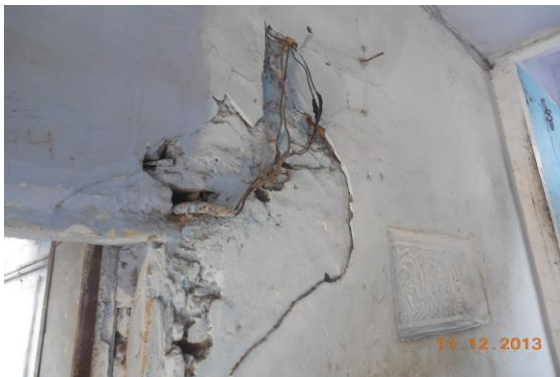
Photo 49
Peeling of Plaster on Wall No. 1 of StairCase of Ground Floor

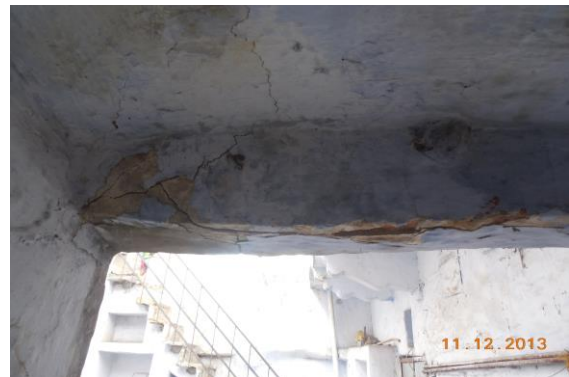
Photo 50
Damaged Portion on Roof of Gate of Ground Floor

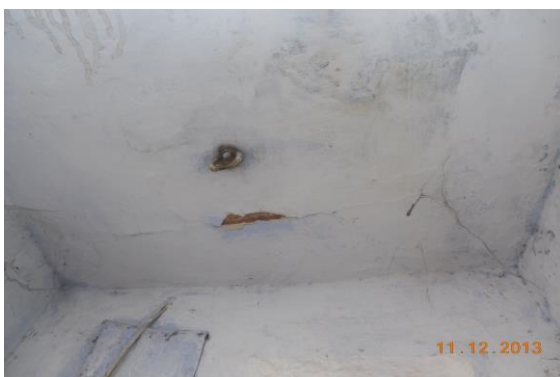
Photo 51
Peeling of Plaster on Wall No. 2 & Roof of Open Sky of First Floor

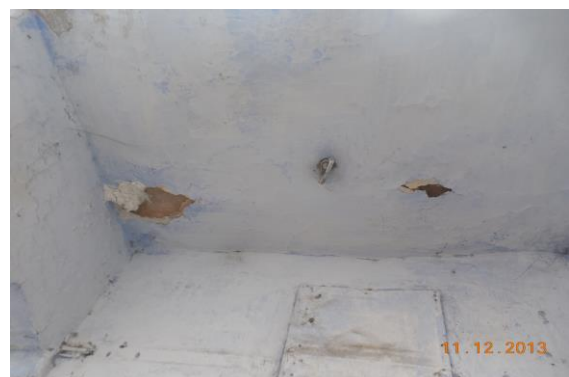
Photo 52
Peeling of Plaster on Wall No. 2 & Roof of Open Sky of First Floor

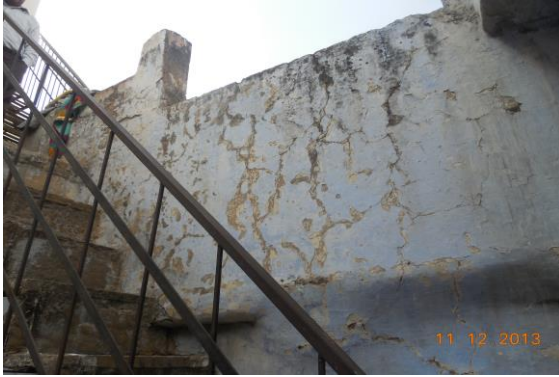
Photo 53
Plaster Crack on Wall No. 4 of Open Sky of First Floor

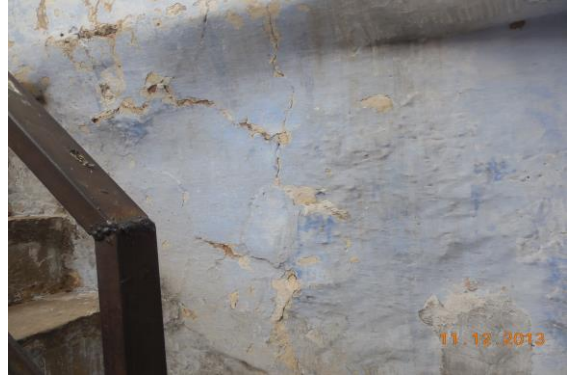
Photo 54
Plaster Crack on Wall No. 4 of Open Sky of First Floor

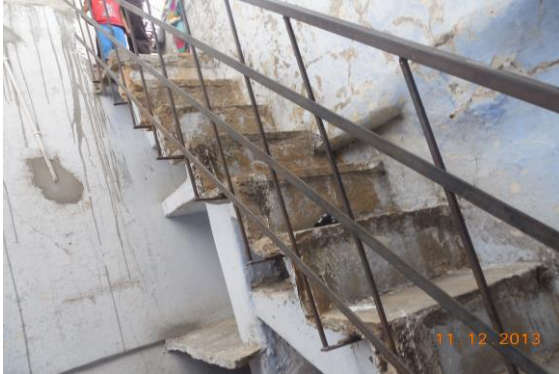
Photo 55
Damaged Portion on Wall No. Stair Step of Open Sky of First Floor

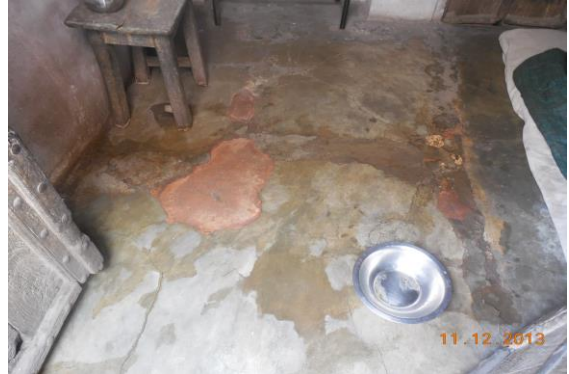
Photo 56
Peeling of Plaster on Wall No. Floor of Room No. 12 of First Floor

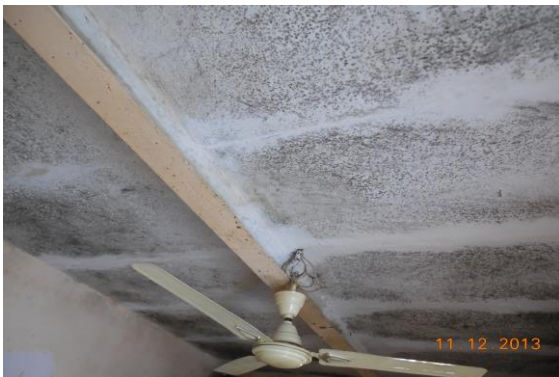
Photo 57
Dampness/Seepage on Roof of Room No. 14 of First Floor

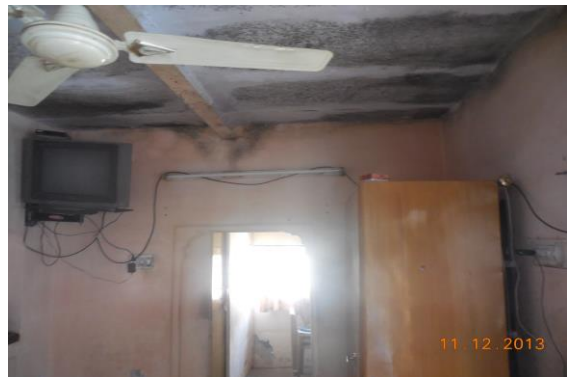
Photo 58
Dampness/Seepage on Wall No. 2 of Room No. 14 of First Floor

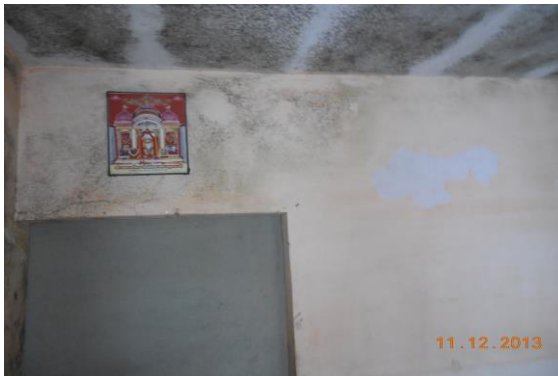
Photo 59

Dampness/Seepage on Wall No. 4 of Room No. 14 of First Floor

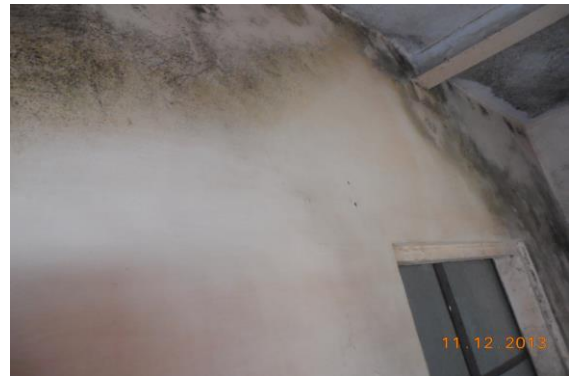
Photo 60

Dampness/Seepage on Wall No. 1 of Room No. 14 of First Floor

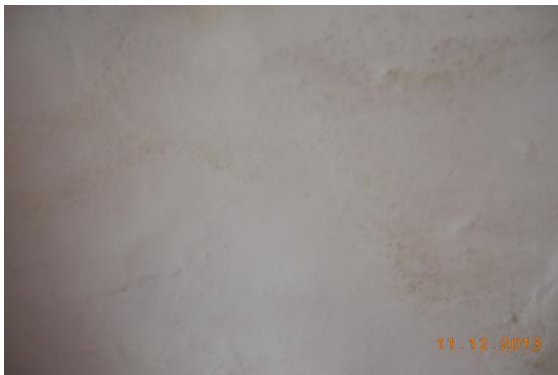
Photo 61

Dampness/Seepage on Roof of Store No.2 of First Floor

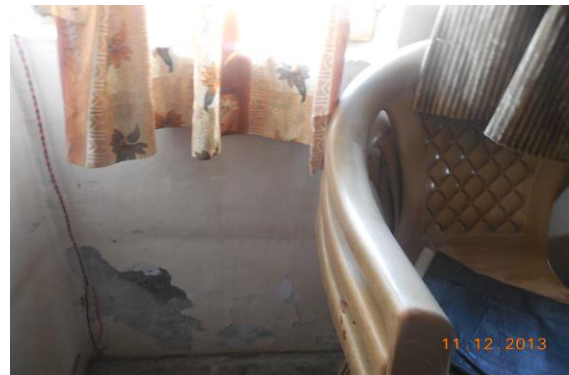
Photo 62

Peeling of Plaster on Wall No. 4 of Store No.2 of First Floor

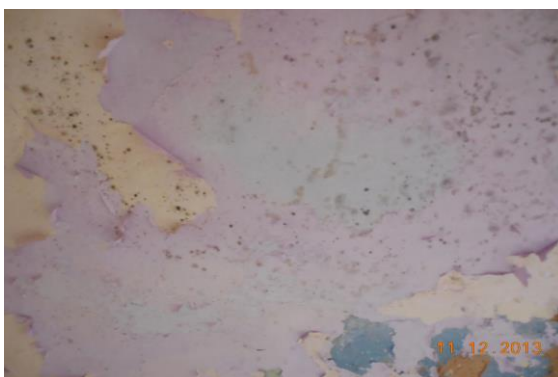
Photo 63

Dampness/Seepage on Roof of Toilet No. Toilet & Washroom of First Floor

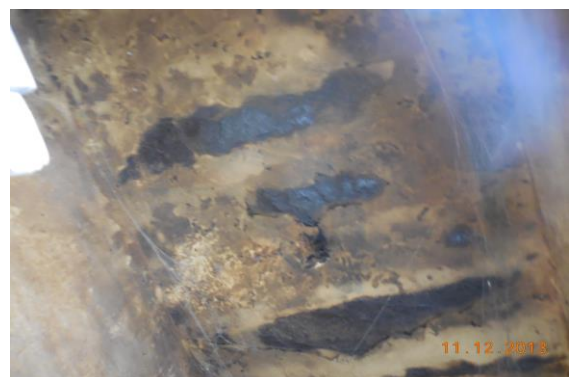
Photo 64

Dampness/Seepage on Roof of Store No.1 of First Floor

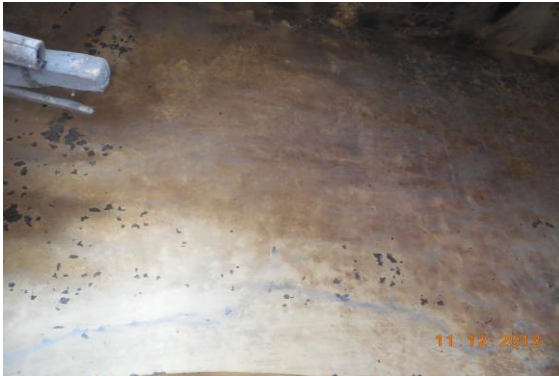
Photo 65
Dampness/Seepage on Wall No. 4 of Store No.1 of First Floor

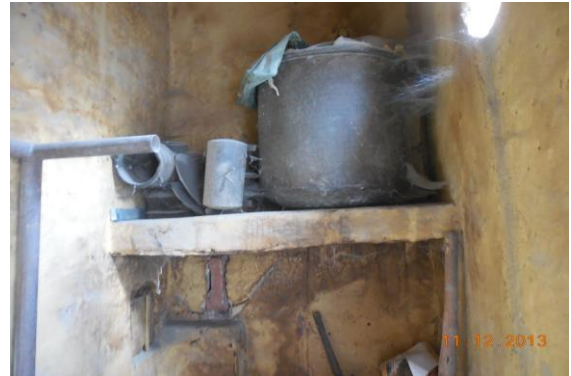
Photo 66
Dampness/Seepage on Wall No. 2 of Store No.1 of First Floor

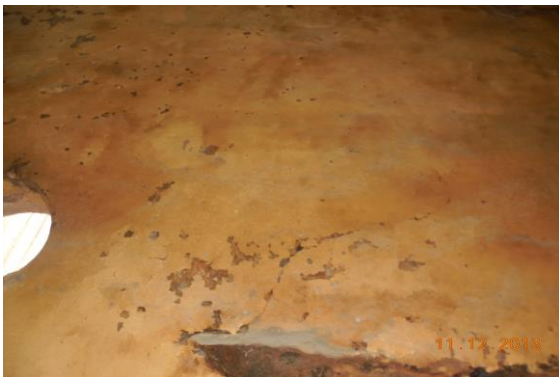
Photo 67
Dampness/Seepage on Wall No. 3 of Store No.1 of First Floor

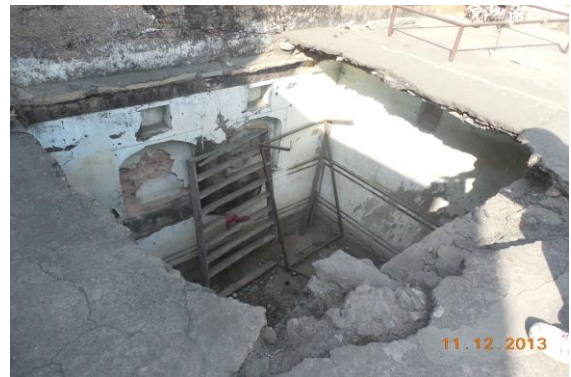
Photo 68
Damaged Portion on Wall No. of Room No. Damage Room of First Floor

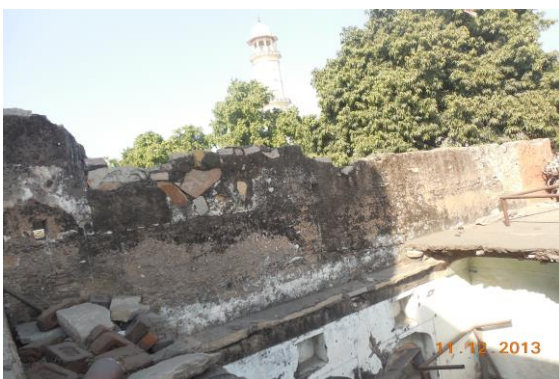
Photo 69
Damaged Portion on Roof of Room No. Damage Room of First Floor

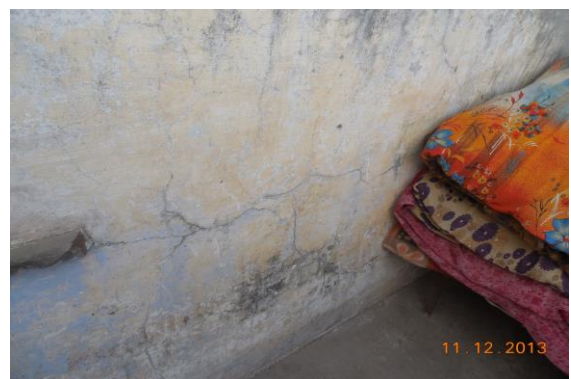
Photo 70
Plaster Crack on Wall No. 1 of Passage of Second Floor

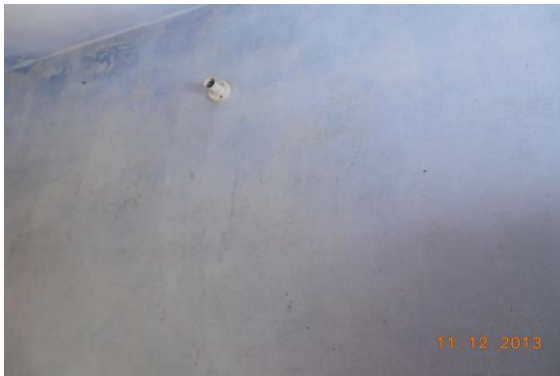
Photo 71

Dampness/Seepage on Wall No. 2 of Room No. 1 of Third Floor

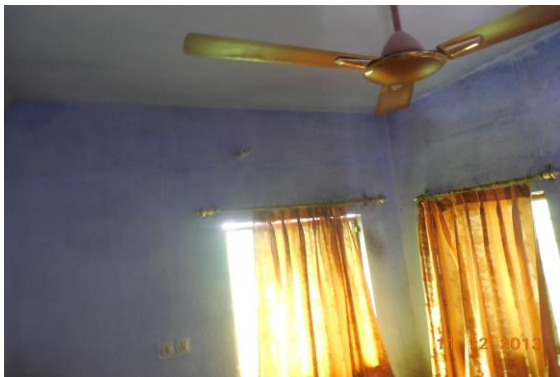
Photo 73

Dampness/Seepage on Wall No. 1 of Room No. 1 of Third Floor

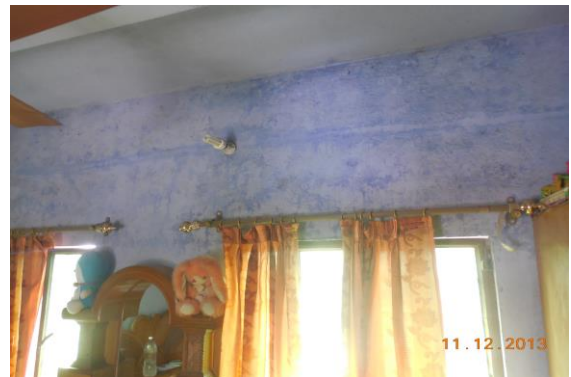
Photo 74

Dampness/Seepage on Wall No. 2 of Room No. 2 of Third Floor

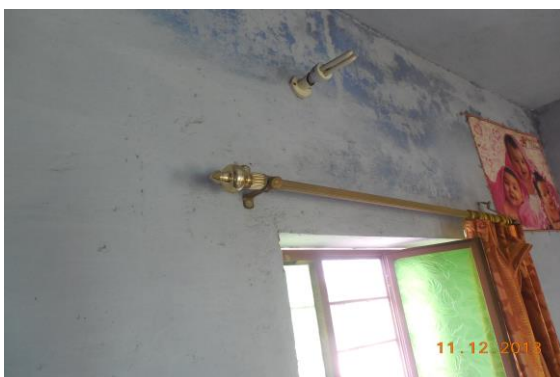
Photo 75

Dampness/Seepage on Wall No. 1 of Room No. 2 of Third Floor

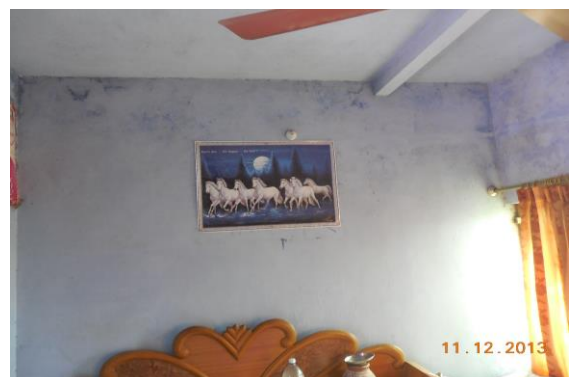
Photo 76

Dampness/Seepage on Wall No. 4 of Room No. 2 of Third Floor

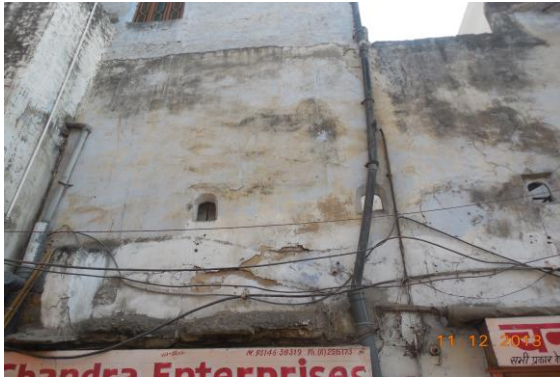
Photo 77
Damaged Portion on Wall No. Outerwall of First Floor

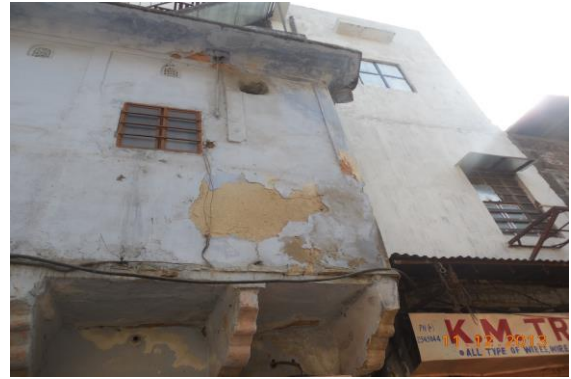
Photo 78
Damaged Portion on Wall No. Outerwall of First Floor

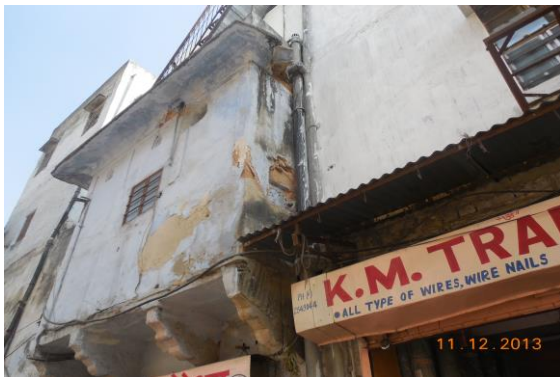
Photo 79
Damaged Portion on Wall No. Outerwall of First Floor

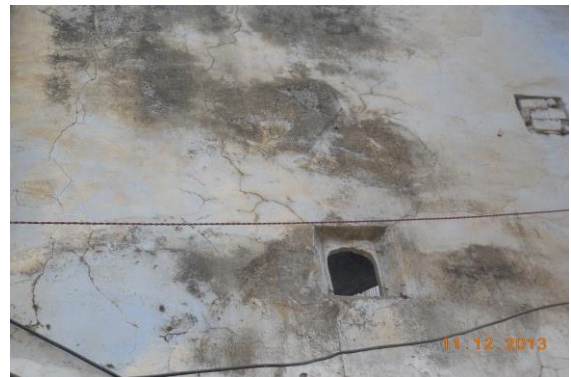
Photo 80
Plaster Crack on Wall No. Outerwall of First Floor

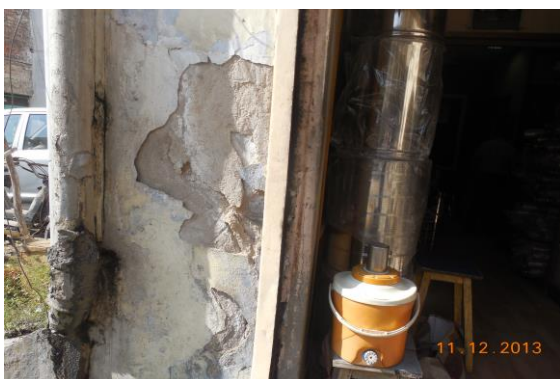
Photo 81
Peeling of Plaster on Wall No. Frontwall of Siyaram Treaders of Ground Floor

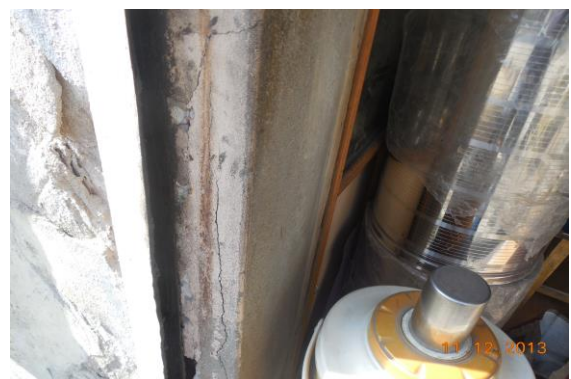
Photo 82
Plaster Crack on Wall No. Frontwall of Siyaram Treaders of Ground Floor

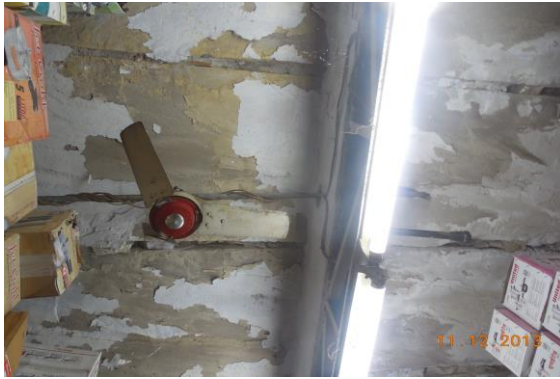
Photo 83

Peeling of Plaster on Roof of Part C of Siyaram Treaders of Ground Floor

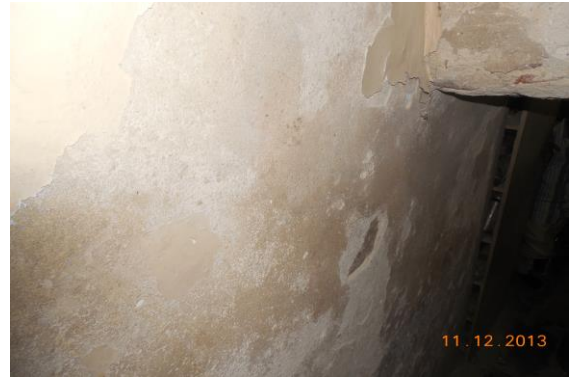
Photo 84

Peeling of Plaster on Wall No. 1 of Staircase area of Basement

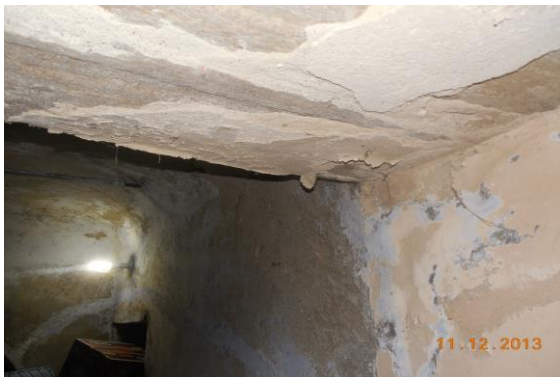
Photo 85

Peeling of Plaster on Wall No. 2 & Roof of Staircase area of Basement

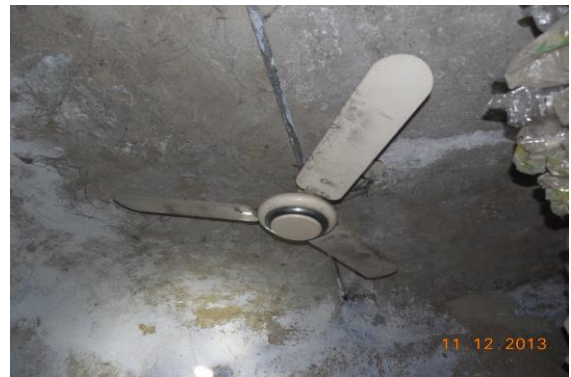
Photo 86

Dampness/Seepage on Roof of Part A of Siyaram Treaders of Basement

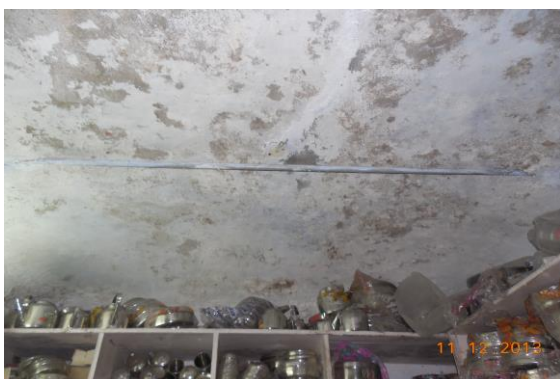
Photo 87

Dampness/Seepage on Roof of Part B of Siyaram Treaders of Ground Floor

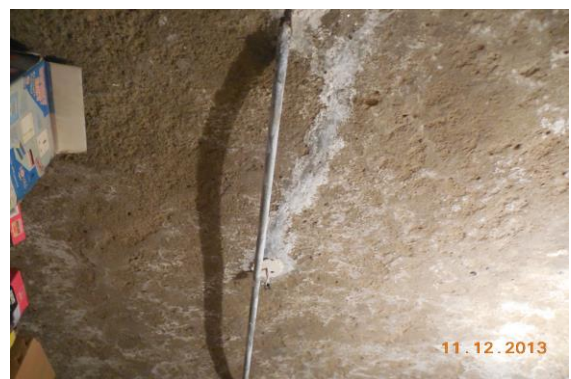
Photo 88

Dampness/Seepage on Roof of Part C of Siyaram Treaders of Ground Floor

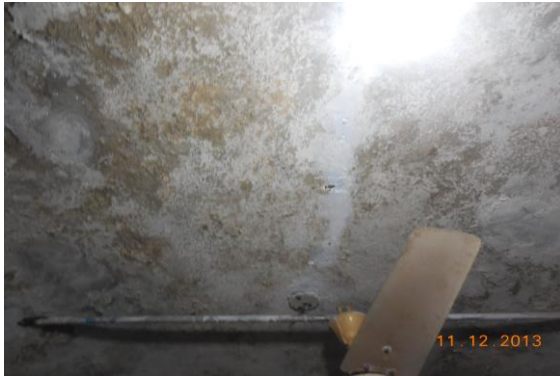
Photo 89

Dampness/Seepage on Roof of Part D of Siyaram Treaders of Ground Floor

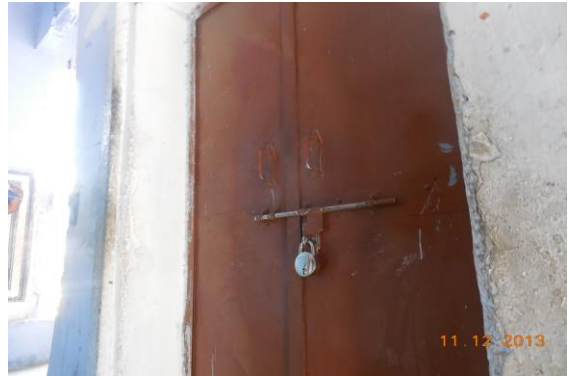
Photo 102
of Room No. 11 of First Floor Locked

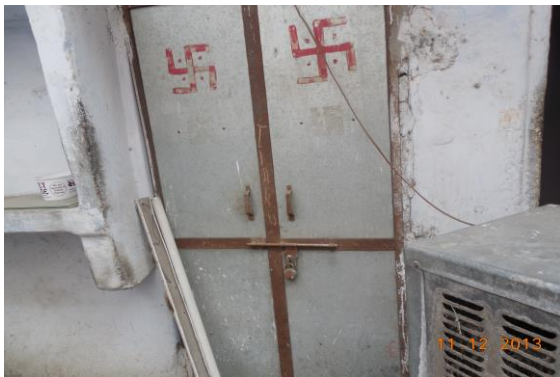
Photo 103
of Room No. 13 of First Floor Locked

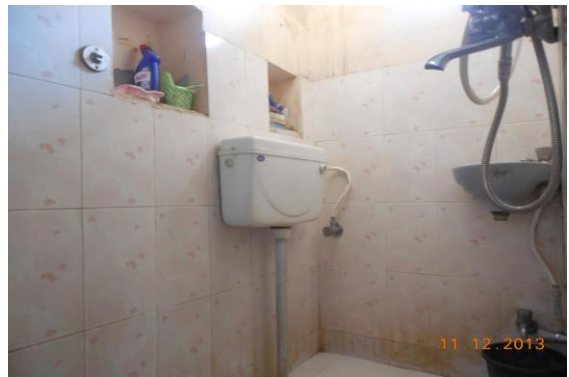
Photo 104
Wall No. All walls & Roof of Toilet No. Toilet & Washroom of First Floor Covered With tiles

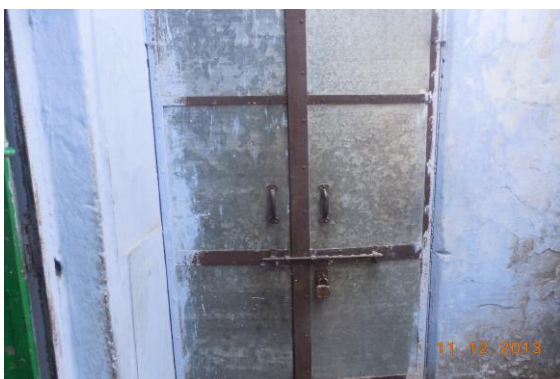
Photo 105
of Store Room of First Floor Locked

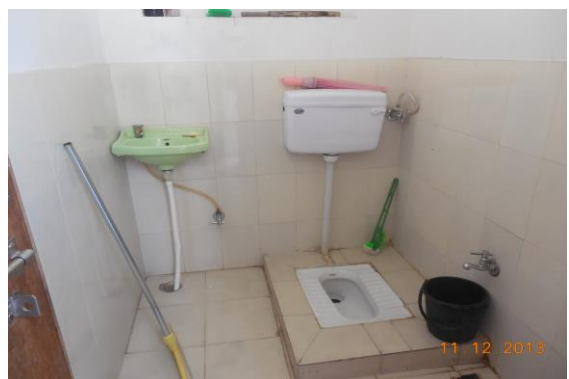
Photo 106
Wall No. All walls of Toilet No. Toilet & Washroom of Second Floor Half Covered with Tile

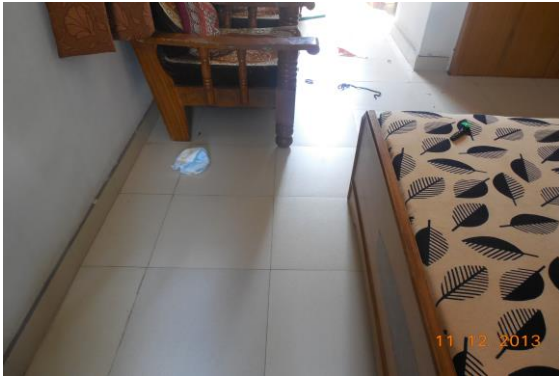
Photo 107

Wall No. Floor of Room No. 1 of Second Floor Covered With Tile

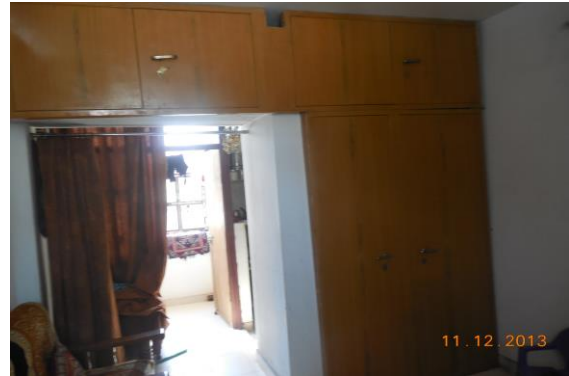
Photo 108

Wall No. 4 of Room No. 1 of Second Floor Covered With Almira

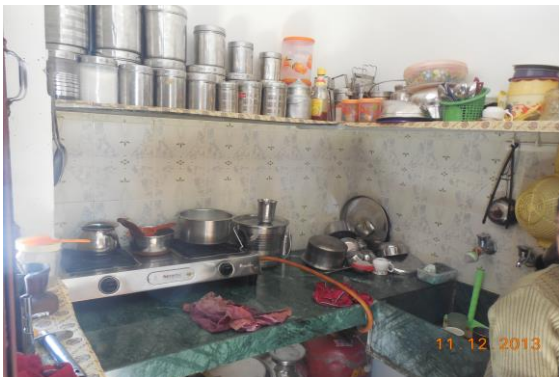
Photo 109

Wall No. 1, 2 & 4 of Kitchen of Second Floor Covered With Tile

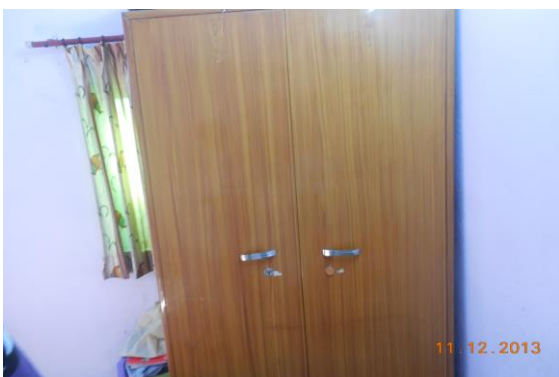
Photo 111

Wall No. 2 of Room No. 2 of Second Floor Half Covered with Almira

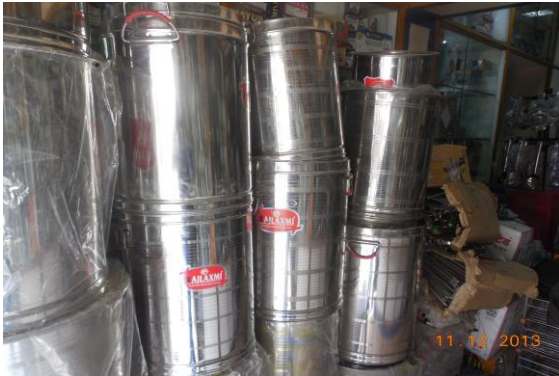
Photo 113

Wall No. 1 of Part A of Siyaram Treaders of Ground Floor Covered With Glass Work & Material

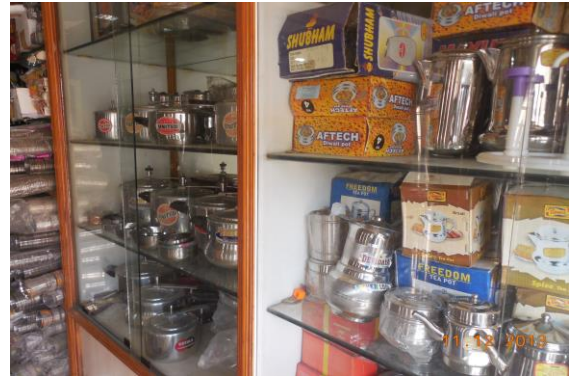
Photo 114

Wall No. 2 of Part A of Siyaram Treaders of Ground Floor Covered With Glass Work & Material

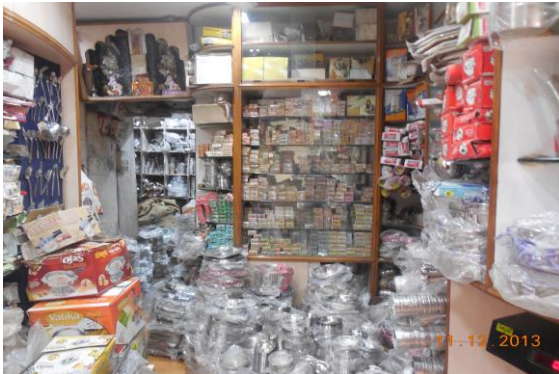
Photo 115

Wall No. All walls of Part B of Siyaram Treaders of Ground Floor Covered With Material

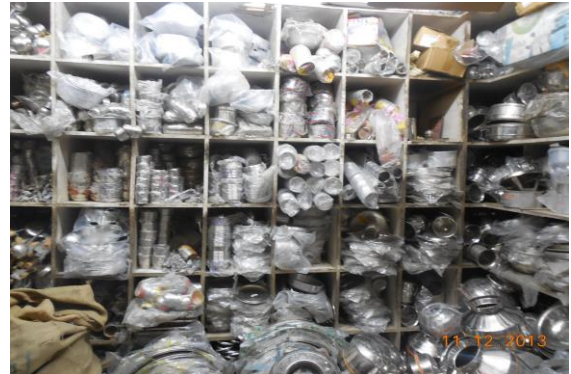
Photo 116

Wall No. All walls of Part A of Siyaram Treaders of Ground Floor Covered With Material

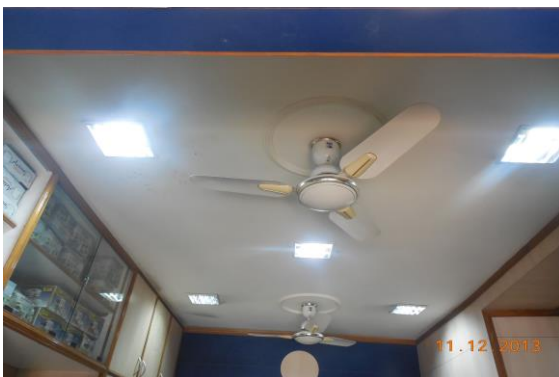
Photo 117

Roof of Part A of Siyaram Treaders of Ground Floor Covered With Falls Ceiling

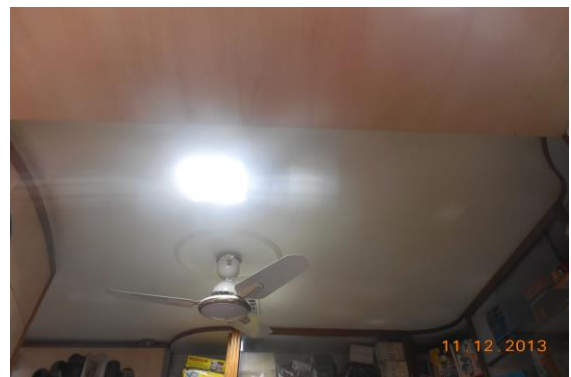
Photo 118

Roof of Part B of Siyaram Treaders of Ground Floor Covered With Falls Ceiling

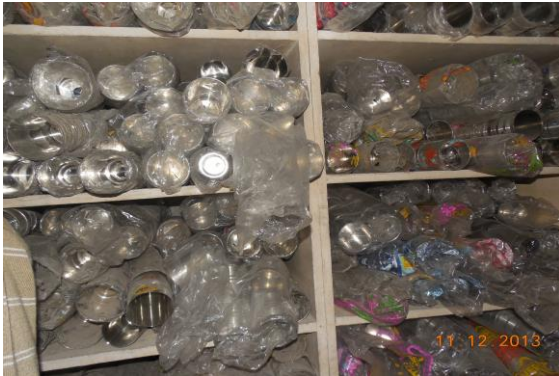
Photo 119

Wall No. 3 of Part A of Siyaram Treaders of Ground Floor Covered With Material

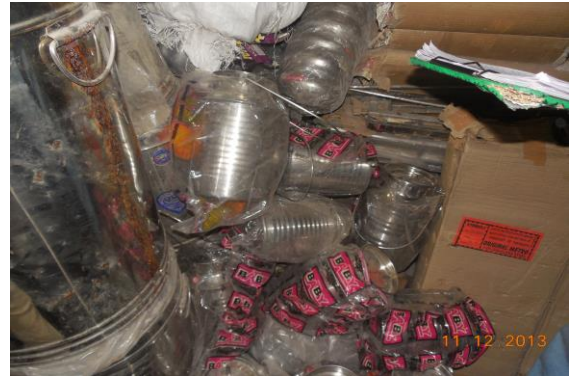
Photo 120

Wall No. 2 of Part A of Siyaram Treaders of Ground Floor Covered With Material

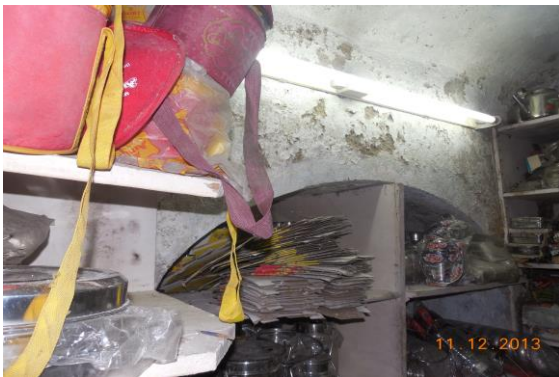
Photo 121

Wall No. 1 of Part B of Siyaram Treaders of Ground Floor Covered With Material

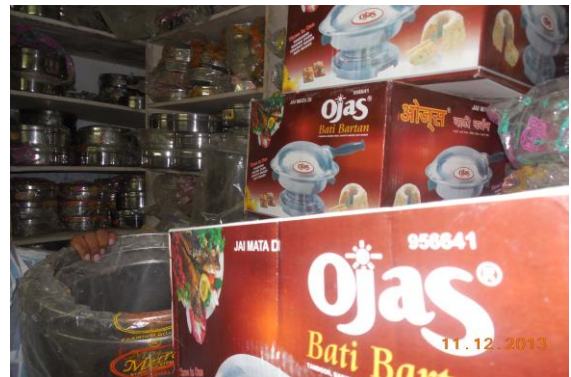
Photo 122

Wall No. 2 of Part B of Siyaram Treaders of Ground Floor Covered With Material

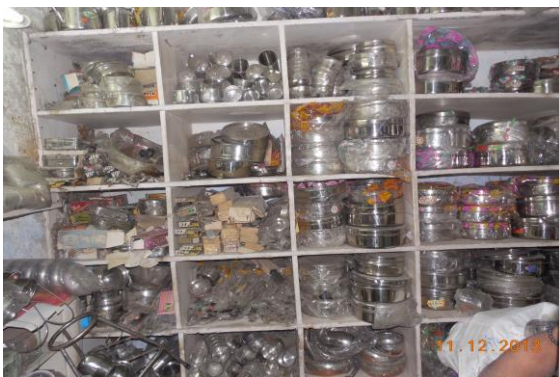
Photo 123

Wall No. 4 of Part B of Siyaram Treaders of Ground Floor Covered With Material

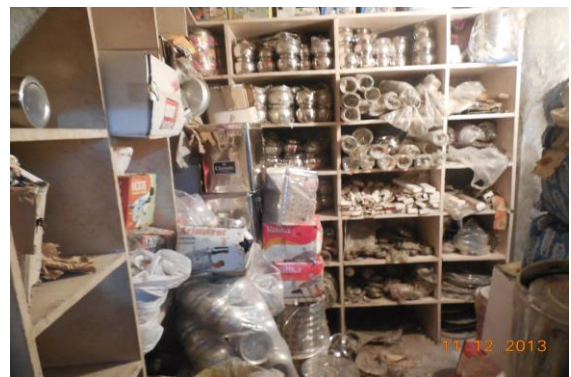
Photo 124

Wall No. 1 & 4 of Part C of Siyaram Treaders of Ground Floor Covered With Material

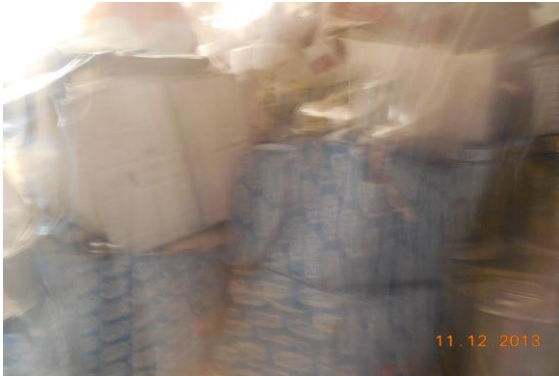
Photo 125

Wall No. 3 of Part C of Siyaram Treaders of Ground Floor Covered With Material

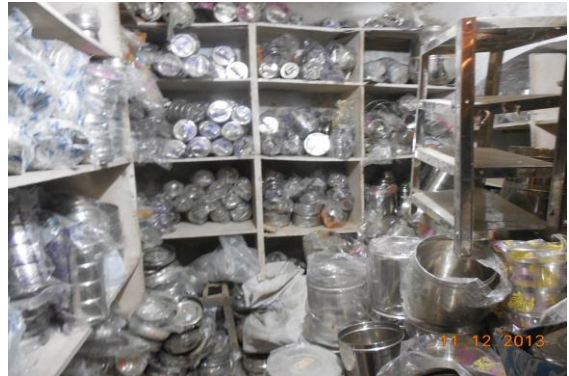
Photo 126

Wall No. All walls of Part D of Siyaram Treaders of Ground Floor Covered With Material

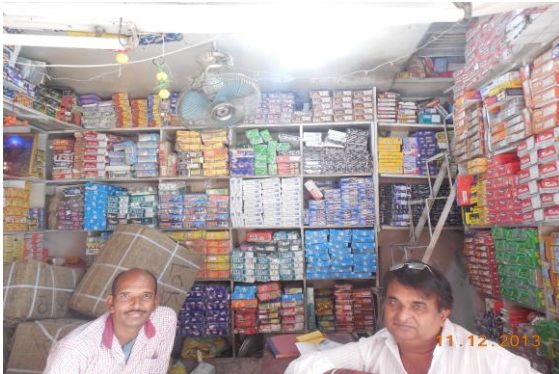
Photo 127

Wall No. All walls of Shop Grover Brothers of Ground Floor Covered With material

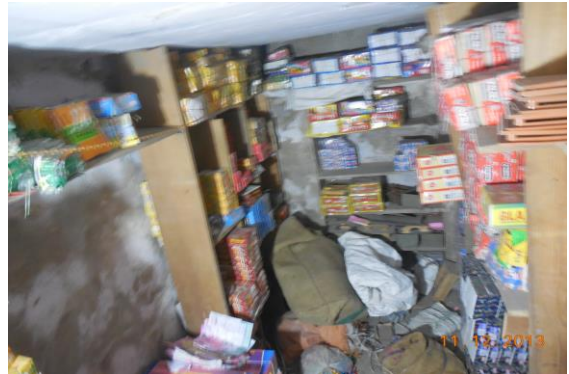
Photo 128

Wall No. All walls of Shop Grover Brothers of Ground Floor Covered With material

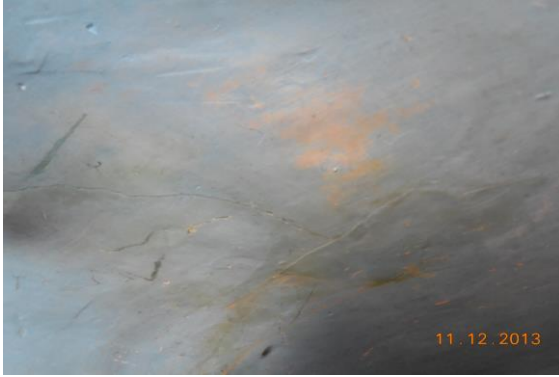
Summary of Defects Other Than Crack			
Defect ID	Location	Description	Photo No.
1	Roof Shade Shop No.196 Ground Floor	Damaged Portion	6
2	Roof Part B of Shop No.197 Ground Floor	Plaster Crack	7
3	Wall No. 2 Part B of Shop No.197 Ground Floor	Peeling of Plaster	8
4	Roof Shade Shop No.198 Ground Floor	Peeling of Plaster	9

Photo 7
Plaster Crack on Roof of Part B of Shop No.197 of Ground Floor

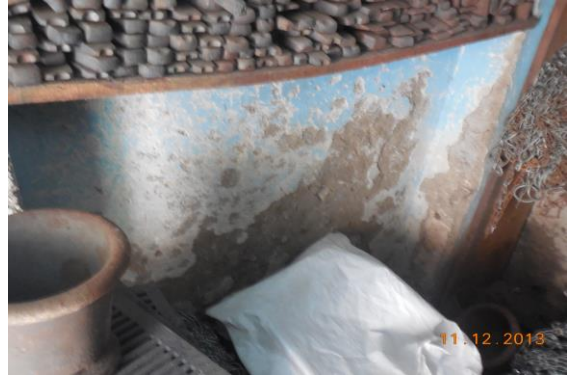
Photo 8
Peeling of Plaster on Wall No. 2 of Part B of Shop No.197 of Ground Floor

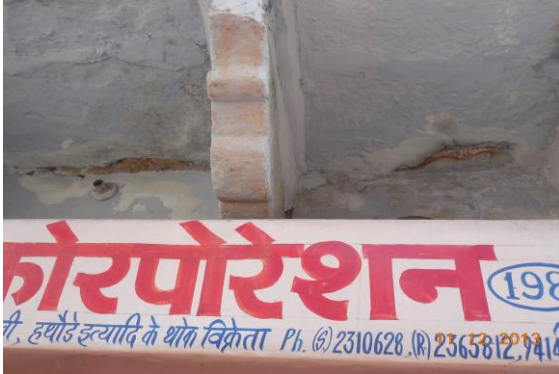
Photo 9
Peeling of Plaster on Roof Shade of Shop No.198 of Ground Floor

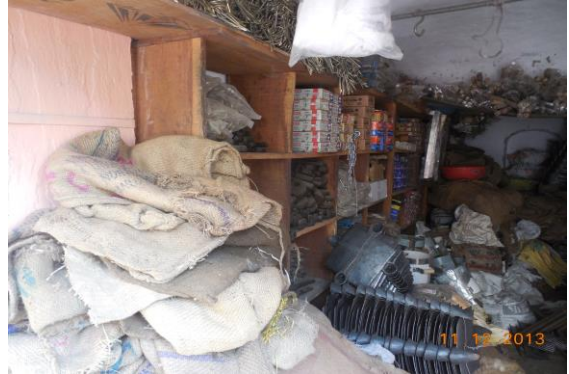
Photo 10
Wall No. 1 of Shop No.196 of Ground Floor Covered With Material

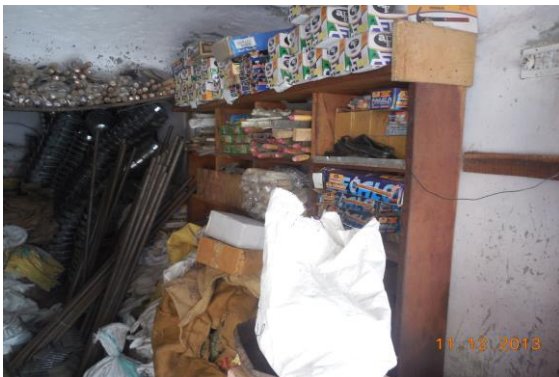
Photo 11
Wall No. 2 of Shop No.196 of Ground Floor Covered With Material

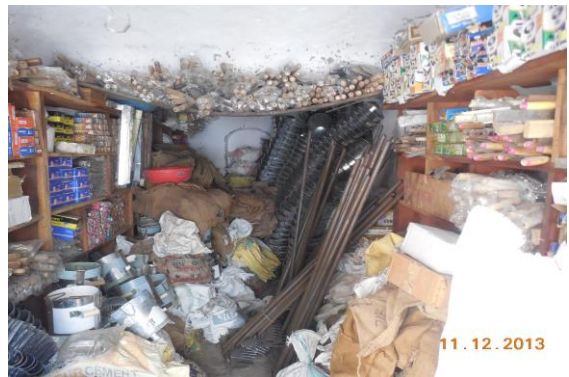
Photo 12
Wall No. 4 of Shop No.196 of Ground Floor Covered With Material

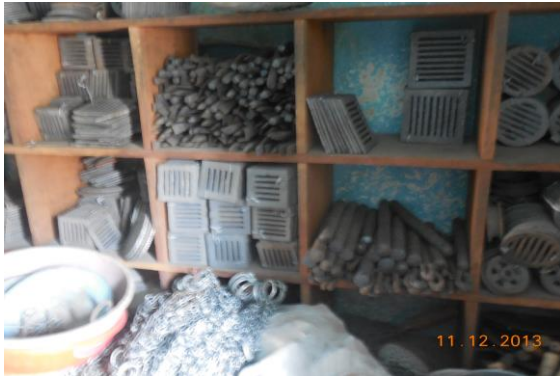
Photo 13

Wall No. 1 of Part B of Shop No.197 of Ground Floor Covered With Material

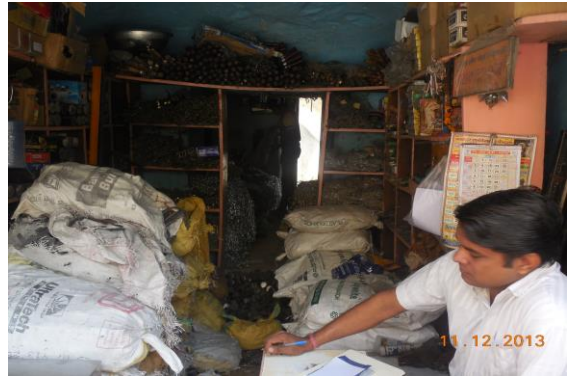
Photo 14

All walls of Part C of Shop No.197 of Ground Floor Covered With Material

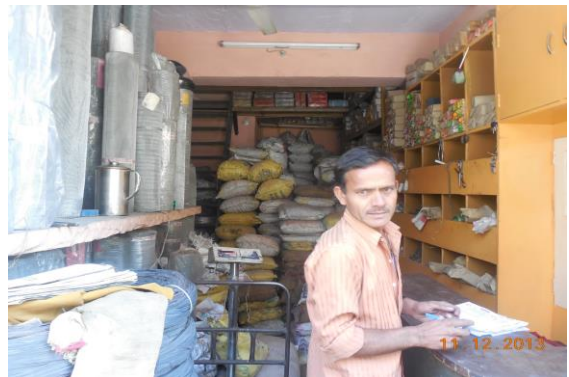
Photo 16

All walls of Shop No.199 of Ground Floor Covered With material

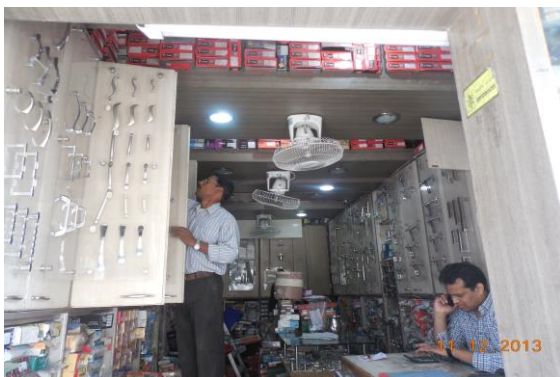
Photo 17

All walls & Roof of Shop Goyal Sales of Ground Floor Covered With material

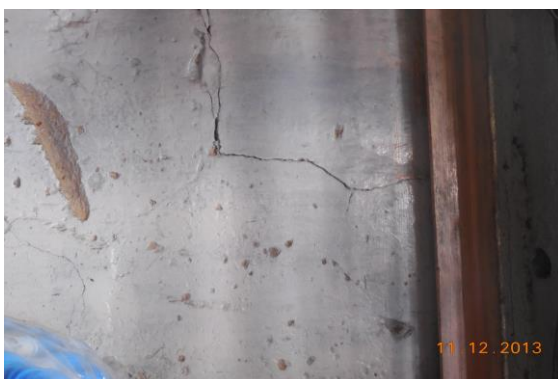
Summary of Cracks						
Defect ID	Location	Orientation	Appx. Width (mm)	Appx. Length (m)	Category	Photo No.
1	Wall No. 2 Shop No. 310 Ground Floor	Inclined	1	0.5	Slight	5
2	Wall No. 2 Shop No. 310 Ground Floor	Inclined	0.5	1	Very Slight	6

Photo 5
Inclined Crack on Wall No. 2 of Shop No. 310, Ground Floor
Approx. Width = 1mm, Approx. Length = 0.5m.
Distance from Gate = 0.35m, Height from Floor = 1.7m.

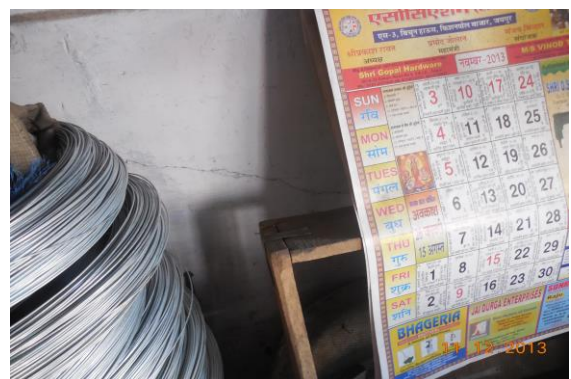
Photo 6
Inclined Crack on Wall No. 2 of Shop No. 310, Ground Floor
Approx. Width = 0.5mm, Approx. Length = 1m.
Distance from Gate = 1.4m, Height from Floor = 1m.

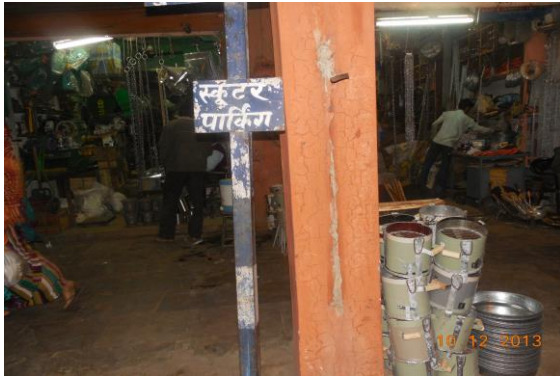
Photo 7

Peeling of Plaster on Pillar of Varanda of Shop No. 309, Ground Floor
