Pre Building Condition Survey Report

Name and Address of Structure :	Choti Chopar to Badi Chopar (Down Line)
---------------------------------	---

Name of the Project	Contract JMRC-UG1B “Design and Construction of Tunnel between Chandpole and Badi Chouper and reverse line by Shield TBM, Underground Metro Stations at Choti Chouper and Badi Chouper by Cut and Cover Methods on East West Corridor of Jaipur Metro Rail Corporation Limited .”	
Owner :

Pre Building Condition Survey Report Choti Chopar to Badi Chopar (Down Line)

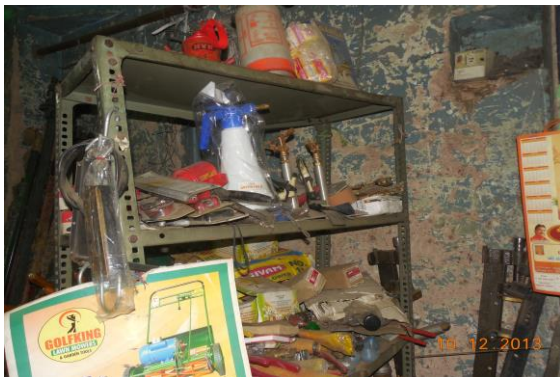
Photo 9

Peeling of Plaster on Wall No. 2 of Shop No. 309 of Ground Floor

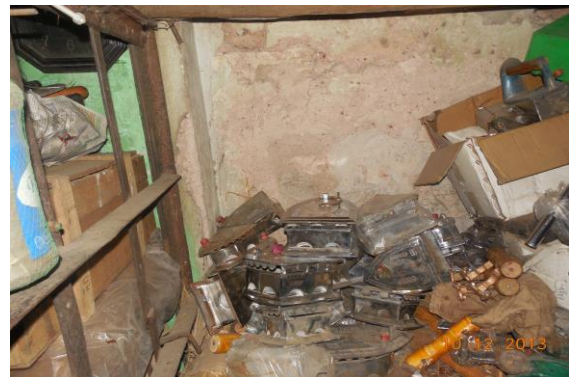
Photo 10

Peeling of Plaster on Wall No. 1 of Shop No. 309 of Ground Floor

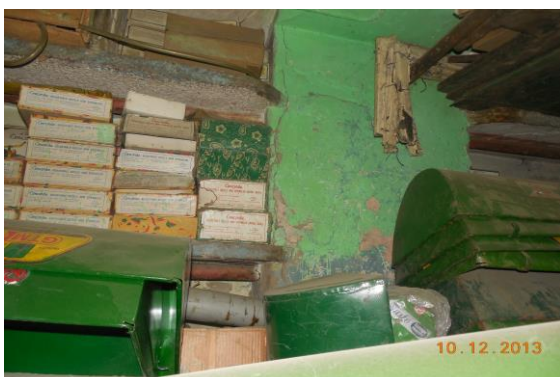
Photo 11

Damaged Portion on Wall No. 1 of Shop No. 309 of Ground Floor

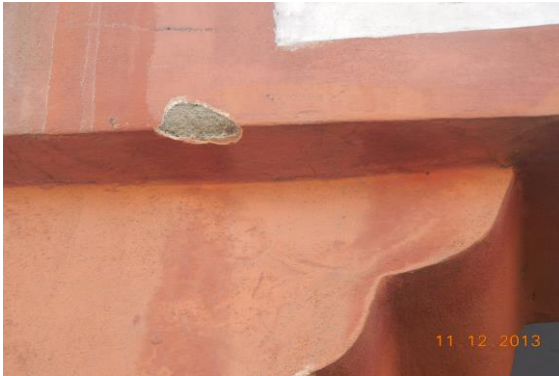
Photo 13

Peeling of Plaster on External Wall left side of Shop No. 310 of Ground Floor

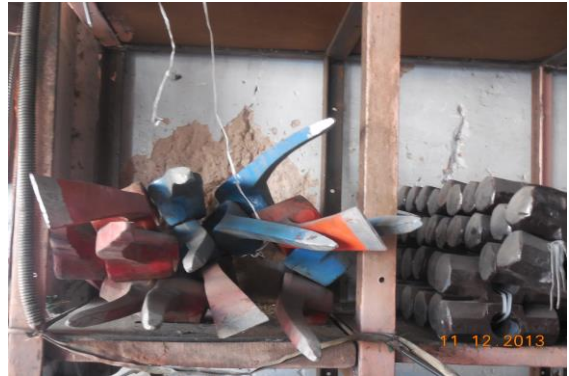
Photo 14

Peeling of Plaster on Wall No. 1 of Shop No. 310 of Ground Floor

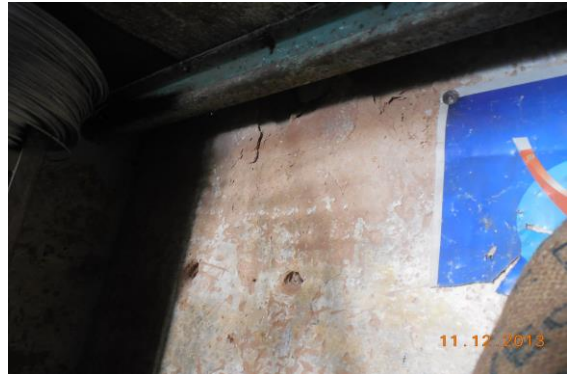
Photo 16

Dampness/Seepage on Wall No. 4 of Shop No. 310 of Ground Floor

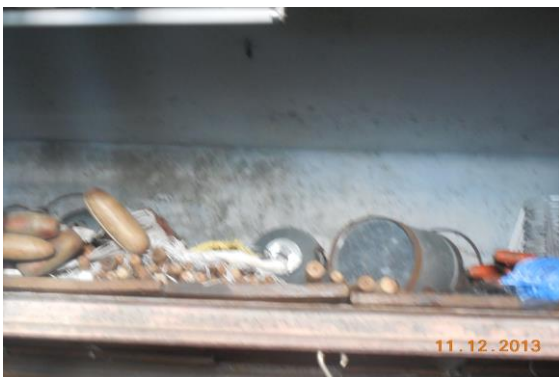
Photo 17

Peeling of Plaster on Wall No. 4 of Shop No. 310 of Ground Floor

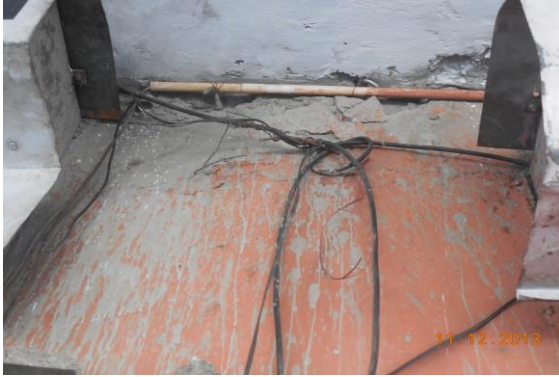
Photo 19
Peeling of Plaster on Wall No. 3 & Out of Side of Shop No. 311 of Ground Floor

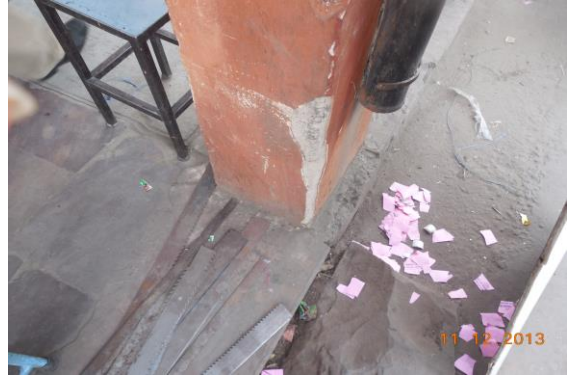
Photo 20
Peeling of Plaster on External Beam Right Side of Shop No. 311 of Ground Floor

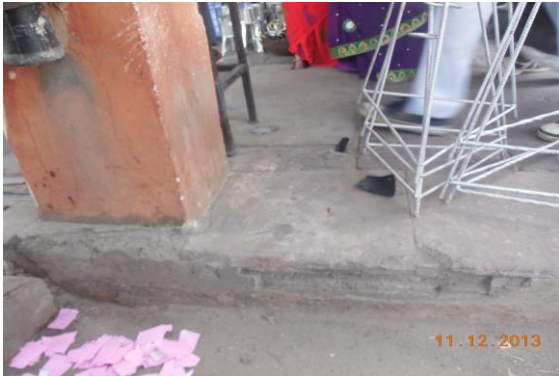
Photo 21
Peeling of Plaster on Floor & Out of Side of Shop No. 312 of Ground Floor

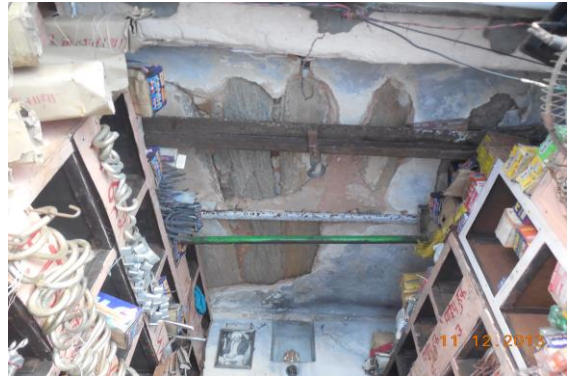
Photo 22
Peeling of Plaster on Roof of Shop No. 312 of Ground Floor

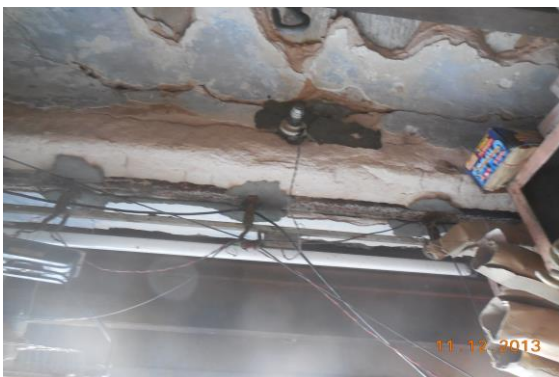
Photo 23
Peeling of Plaster on Wall No. 3 of Shop No. 312 of Ground Floor

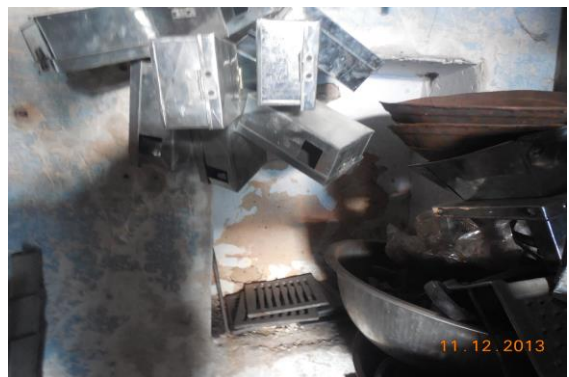
Photo 24
Peeling of Plaster on Wall No. 4 of Shop No. 312 of Ground Floor

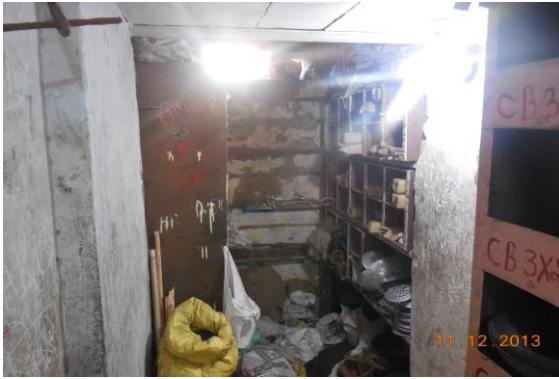
Photo 25

Dampness/Seepage on Wall No. 1 of Shop No. 312 of Basement

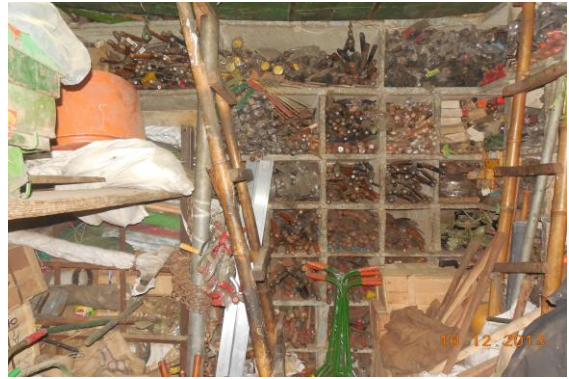
Photo 26

Wall No. 4 of Shop No. 309 of Ground Floor Covered With Material

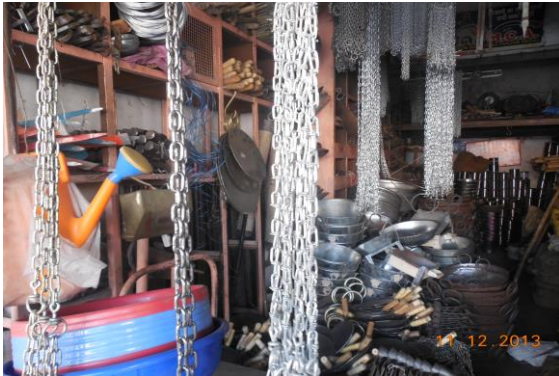
Photo 27

Wall No. 1 of Shop No. 310 of Ground Floor Covered With Material

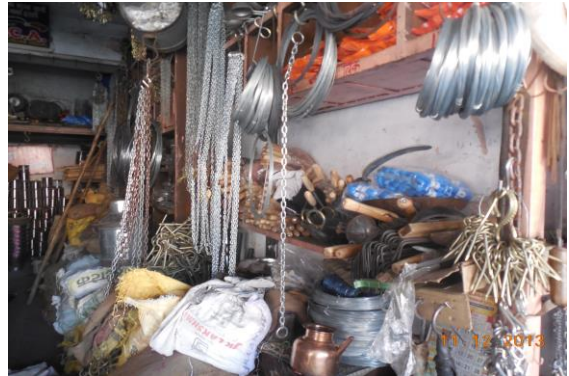
Photo 28

Wall No. 2 of Shop No. 310 of Ground Floor Covered With Material

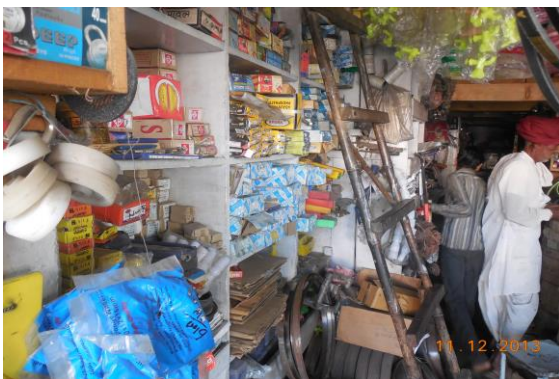
Photo 29

Wall No. 2 of Shop No. 311 of Ground Floor Covered With Material

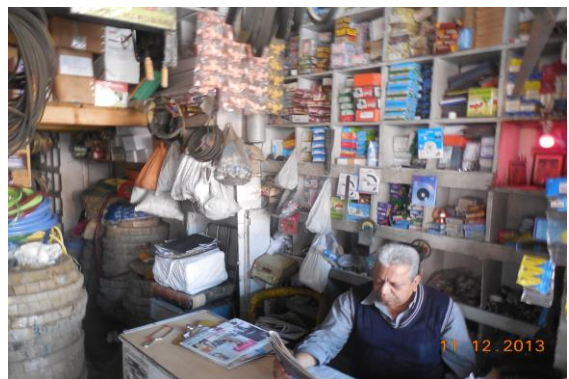
Photo 30

Wall No. 1 of Shop No. 311 of Ground Floor Covered With Material

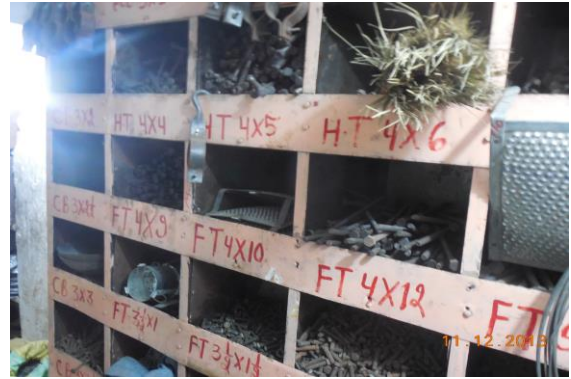
Photo 32
Wall No. 4 of Shop No. 312 of Basement Covered with Material

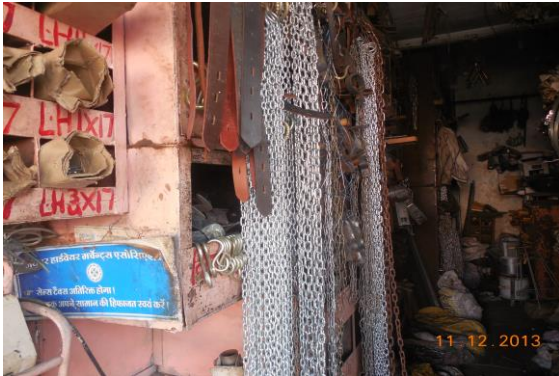
Photo 33
Wall No. 1 & 2 of Shop No. 312 of Ground Floor Covered with Material

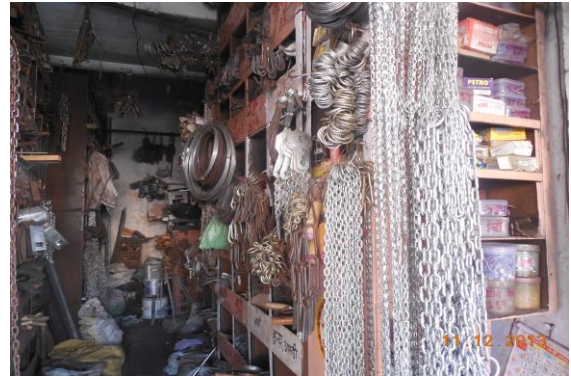
Photo 34
Wall No. 1 & 2 of Shop No. 312 of Ground Floor Covered with Material

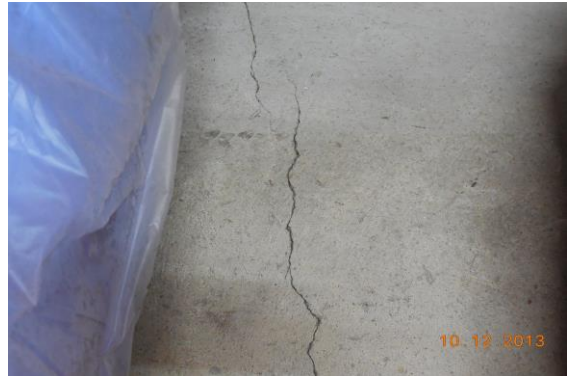
Photo 20
Vertical Crack on Wall No. 4 of Shop No. 298, Ground Floor, Approx. Width = 1mm, Approx. Length = 0.5m. Distance from Wall No. 1 = 1m, Height from Floor = 1.8m.

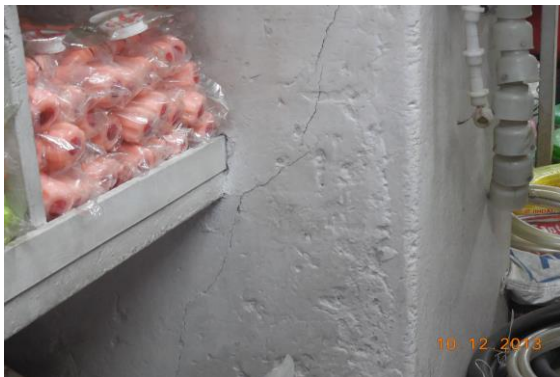
Photo 21
Inclined Crack on Wall No. 1 & Beam Portion of Shop No. 298, Ground Floor, Approx. Width = 1mm, Approx. Length = 1.5m. Distance from Wall No. 3 = 2m, Height from Floor = 0m.

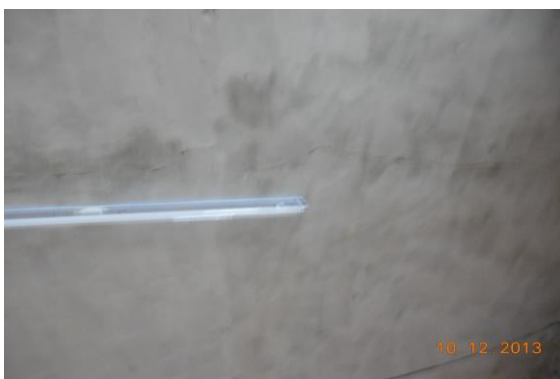
Photo 22
Horizontal Crack on Roof of Varanda, Shop No. 304, Ground Floor, Approx. Width = 0.8mm, Approx. Length = 3m. Distance from Left Side External Column = 0m, Height from Floor = 3m.

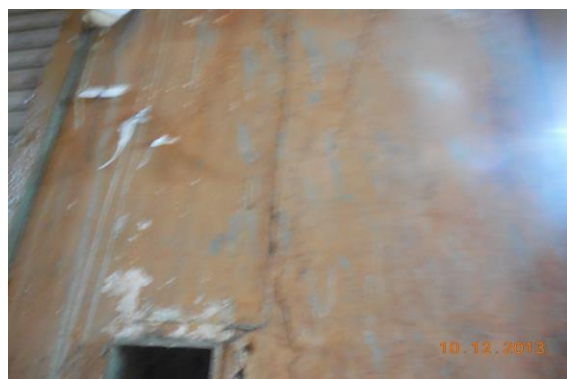
Photo 23
Inclined Crack on Wall No. 3 & Outer wall of Shop of Varanda, Shop No. 304, G. F., Approx. Width = 0.35mm, Approx. Length = 1.5m. Distance from Main Door = 0.4m, Height from Floor = 1.5m.

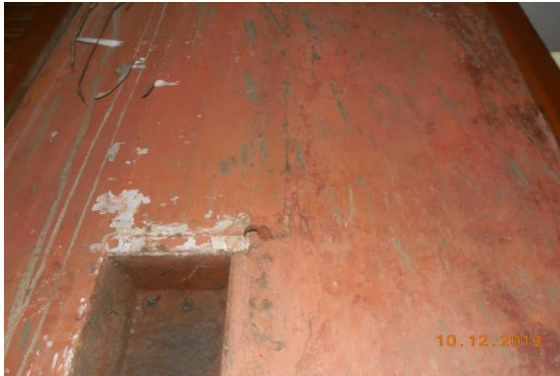
Photo 24

Inclined Crack on Wall No. 3 & Outer wall of Shop of Varanda , Shop No. 304, Ground Floor, Approx. Width = 0.35mm, Approx. Length = 1.5m. Distance Main Door = 0.4m, Height Floor = 1.5m.

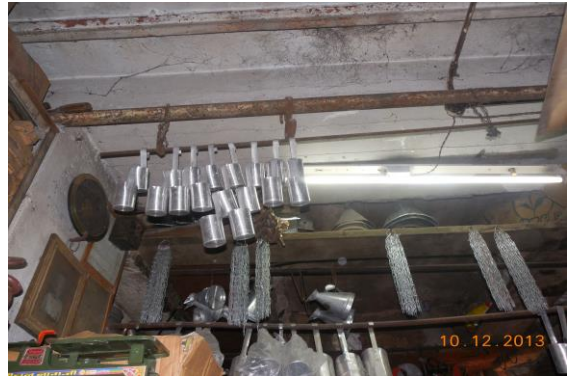
Photo 25

Horizontal Crack on Roof of Part A , Shop No. 308, Ground Floor, Approx. Width = 2mm, Approx. Length = 3m. Distance from Wall No. 3 = 3m, Height from Floor = 3m.

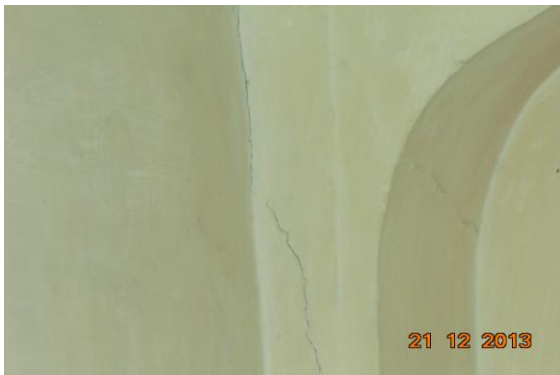
Photo 26

Inclined Crack on Wall No. 3 of Open Sky, Ground Floor
Approx. Width = 0.6mm, Approx. Length = 2.5m.
Distance from Wall No.3 & 4 = 0m, Height from Floor = 3m.

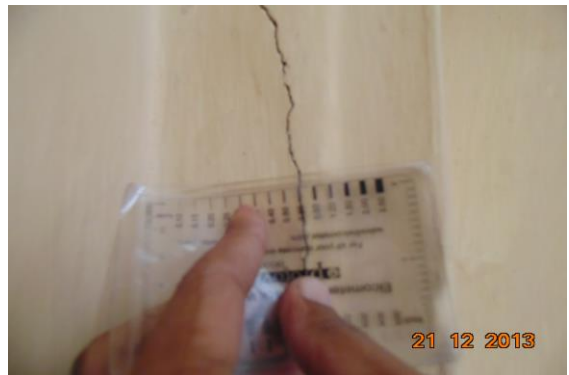
Photo 26A

Inclined Crack on Wall No. 3 of Open Sky, Ground Floor
Approx. Width = 0.6mm, Approx. Length = 2.5m.
Distance from Wall No.3 & 4 = 0m, Height from Floor = 3m.

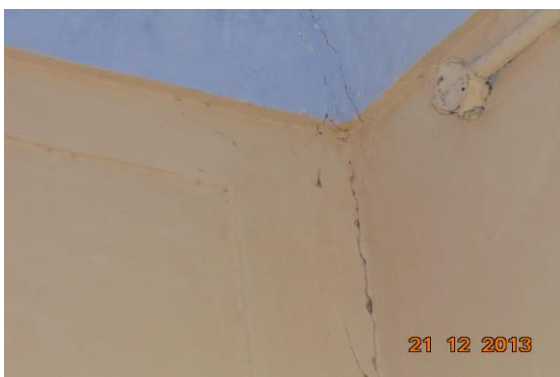
Photo 27

Inclined Crack on Wall No. 3 & 4 of Varanda, Ground Floor
Approx. Width = 1mm, Approx. Length = 3m.
Distance from Wall No.1 = 1m, Height from Floor = 2m.

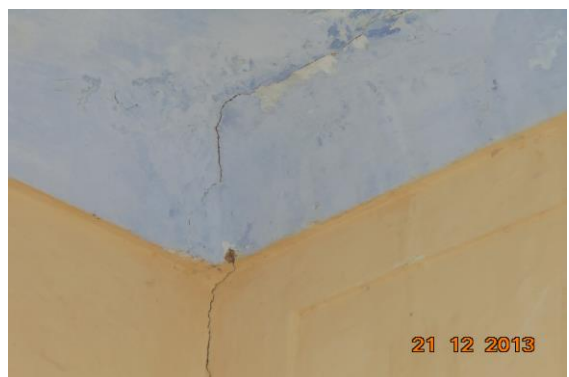
Photo 27A

Inclined Crack on Wall No. 3 & 4 of Varanda, Ground Floor
Approx. Width = 1mm, Approx. Length = 3m.
Distance from Wall No.1 = 1m, Height from Floor = 2m.

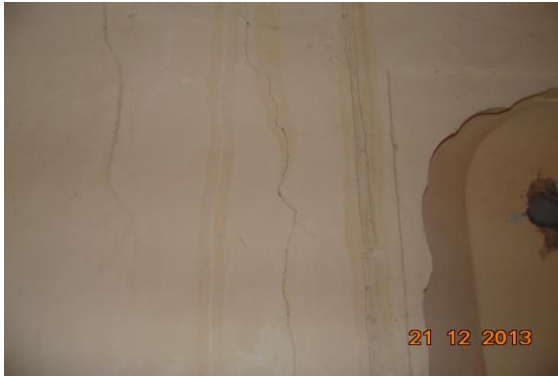
Photo 28

Inclined Crack on Wall No. 4 of Varanda, Ground Floor
Approx. Width = 0.5mm, Approx. Length = 3m.
Distance from Wall No.1 = 2.5m, Height from Floor = 0m.

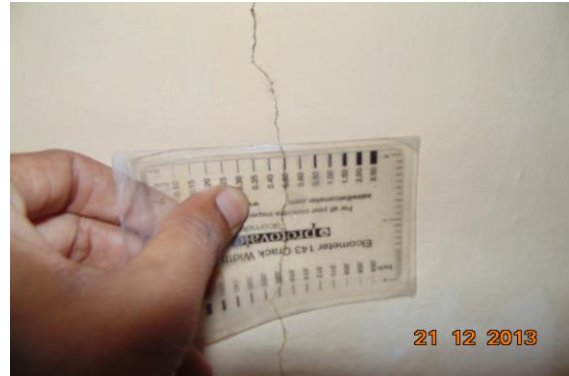
Photo 28A

Inclined Crack on Wall No. 4 of Varanda, Ground Floor
Approx. Width = 0.5mm, Approx. Length = 3m.
Distance from Wall No.1 = 2.5m, Height from Floor = 0m.

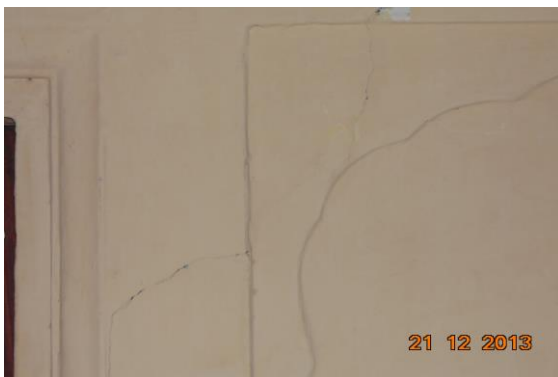
Photo 31

Inclined Crack on Wall No. 1 of Passage No.1, Ground Floor
Approx. Width = 0.8mm, Approx. Length = 1.2m.
Distance from Wall no.1 = 1m, Height from Floor = 0m.

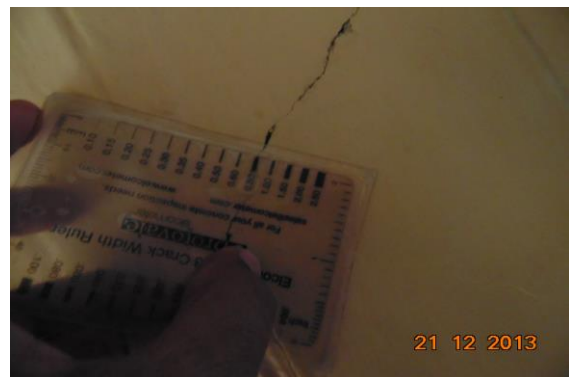
Photo 31A

Inclined Crack on Wall No. 1 of Passage No.1, Ground Floor
Approx. Width = 0.8mm, Approx. Length = 1.2m.
Distance from Wall no.1 = 1m, Height from Floor = 0m.

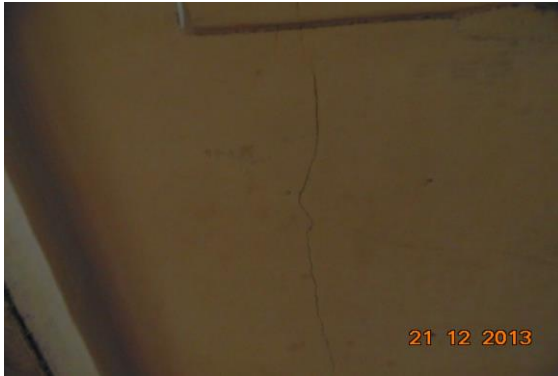
Photo 32

Inclined Crack on Wall No. 1 of Passage No.1, Ground Floor
Approx. Width = 0.35mm, Approx. Length = 1m.
Distance from Wall no.3 = 4m, Height from Floor = 0.1m.

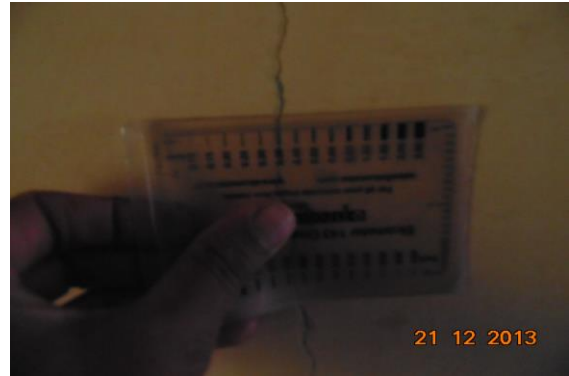
Photo 32A

Inclined Crack on Wall No. 1 of Passage No.1, Ground Floor
Approx. Width = 0.35mm, Approx. Length = 1m.
Distance from Wall no.3 = 4m, Height from Floor = 0.1m.

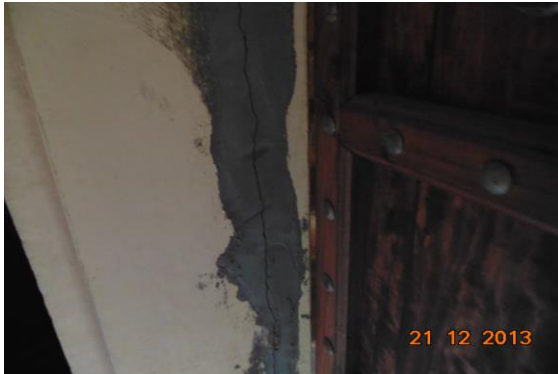
Photo 33

Vertical Crack on Wall No. 1 of Passage No.1, Ground Floor
Approx. Width = 0.8mm, Approx. Length = 1m.
Distance from Wall No.4 = 0.6m, Height from Floor = 0.1m.

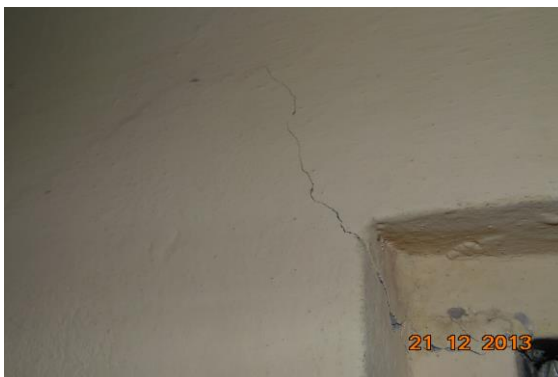
Photo 33A

Vertical Crack on Wall No. 1 of Passage No.1, Ground Floor
Approx. Width = 0.8mm, Approx. Length = 1m.
Distance from Wall No.4 = 0.6m, Height from Floor = 0.1m.

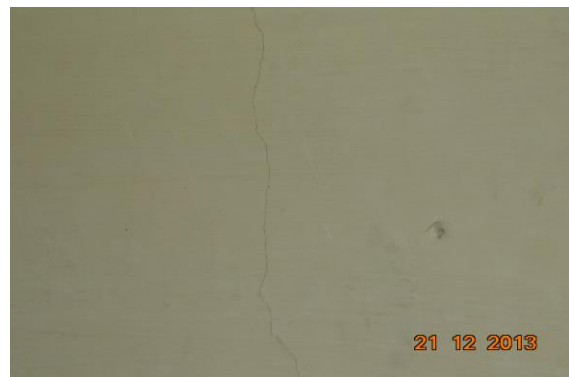
Photo 34

Inclined Crack on Wall No. 2 of Passage No.2, Ground Floor
Approx. Width = 0.3mm, Approx. Length = 0.2m.
Distance from Wall No.4 = 0.3m, Height from Floor = 1.6m.

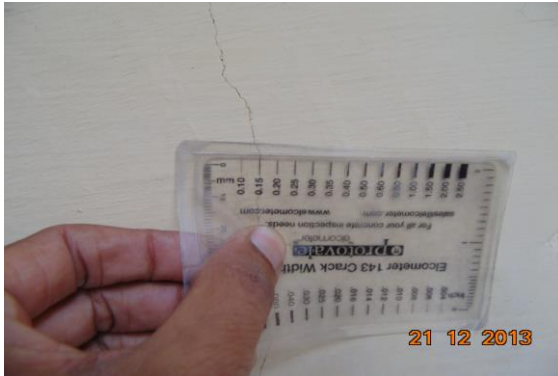
Photo 35

Inclined Crack on Wall No. 3 of Open Sky No.2, Ground Floor
Approx. Width = 0.15mm, Approx. Length = 2m.
Distance from Wall No.1 = 2.5m, Height from Floor = 0.4m.

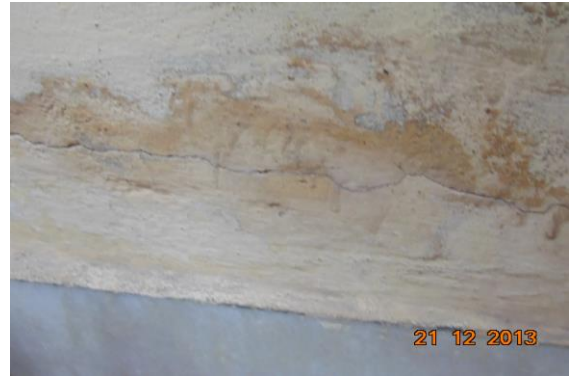
Photo 35A

Inclined Crack on Wall No. 3 of Open Sky No.2, Ground Floor
Approx. Width = 0.15mm, Approx. Length = 2m.
Distance from Wall No.1 = 2.5m, Height from Floor = 0.4m.

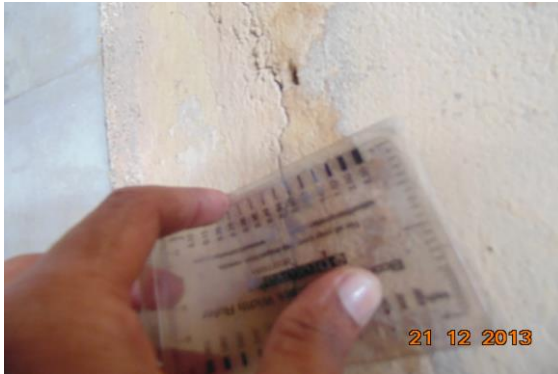
Photo 36

Horizontal Crack on Wall No. 4 of Passage No.3, Ground Floor
Approx. Width = 0.6mm, Approx. Length = 1.2m.
Distance from Main gate = 0m, Height from Floor = 0.15m.

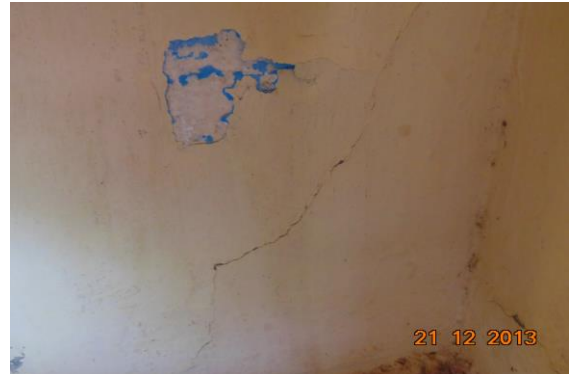
Photo 36A

Horizontal Crack on Wall No. 4 of Passage No.3, Ground Floor
Approx. Width = 0.6mm, Approx. Length = 1.2m.
Distance from Main gate = 0m, Height from Floor = 0.15m.

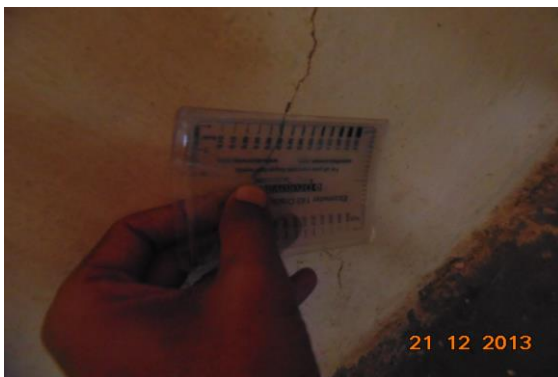
Photo 37

Inclined Crack on Wall No. 3 of Room No. 5, Temple, Ground Floor
Approx. Width = 0.35mm, Approx. Length = 0.4m.
Distance from Wall no.1 = 0m, Height from Floor = 0.1m.

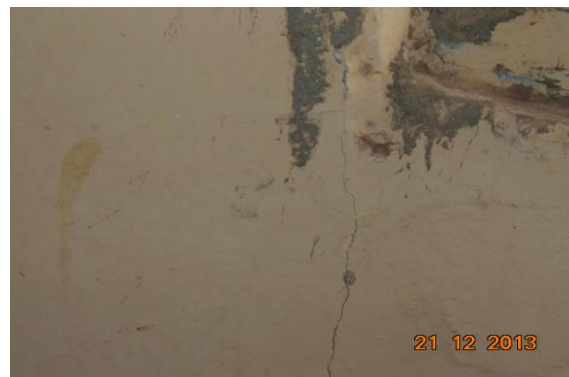
Photo 37A

Inclined Crack on Wall No. 3 of Room No. 5, Temple, Ground Floor
Approx. Width = 0.35mm, Approx. Length = 0.4m.
Distance from Wall no.1 = 0m, Height from Floor = 0.1m.

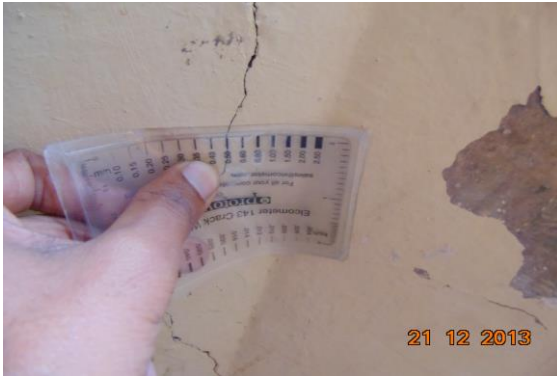
Photo 38

Inclined Crack on Wall No. 4 of Room No. 1, Temple, Ground Floor
Approx. Width = 0.5mm, Approx. Length = 2m.

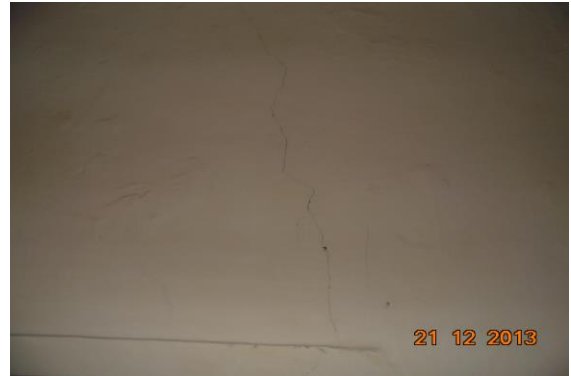
Photo 38A

Inclined Crack on Wall No. 4 of Room No. 1, Temple, Ground Floor
Approx. Width = 0.5mm, Approx. Length = 2m.

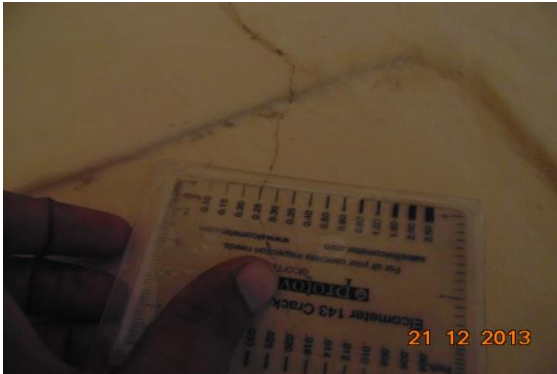
Photo 39

Inclined Crack on Wall No. 4 of Room No. 1, Temple, Ground Floor
Approx. Width = 0.25mm, Approx. Length = 2.5m.
Distance from Wall no.1 = 1m, Height from Floor = 0.2m.

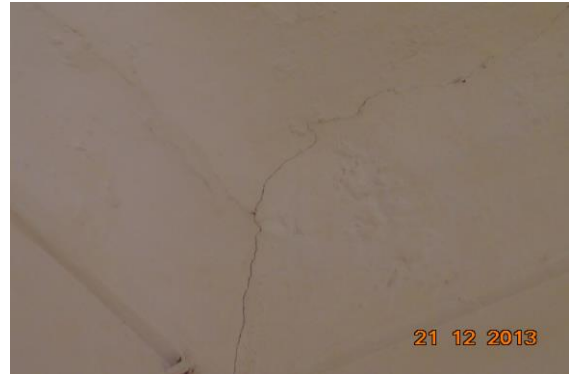
Photo 39A

Inclined Crack on Wall No. 4 of Room No. 1, Temple, Ground Floor
Approx. Width = 0.25mm, Approx. Length = 2.5m.
Distance from Wall no.1 = 1m, Height from Floor = 0.2m.

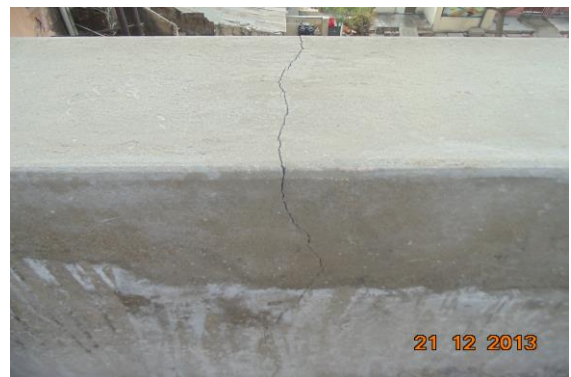
Photo 41

Inclined Crack on Wall No. 3 of Room No. 1, Temple, Ground Floor
Approx. Width = 0.5mm, Approx. Length = 1m.
Distance from Wall no.2 = 1.5m, Height from Floor = 1.7m.

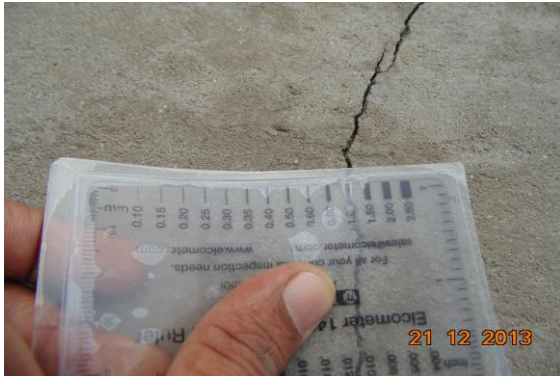
Photo 42

Inclined Crack on Wall No. 2 & parapet Wall of Temple, Terrace
Approx. Width = 1mm, Approx. Length = 0.9m.
Distance from Wall no.3 = 12m, Height from Floor = 0m.

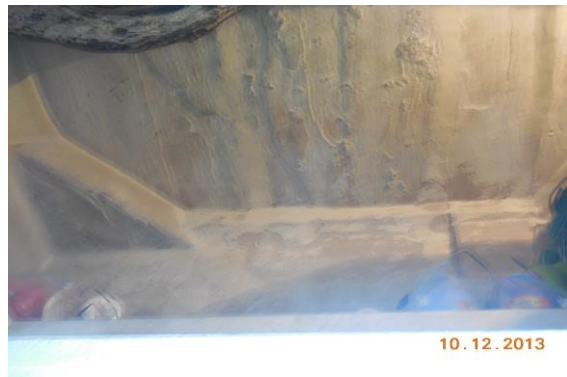
Photo 44

Peeling of Plaster on Roof of Shop No. 298 of Ground Floor

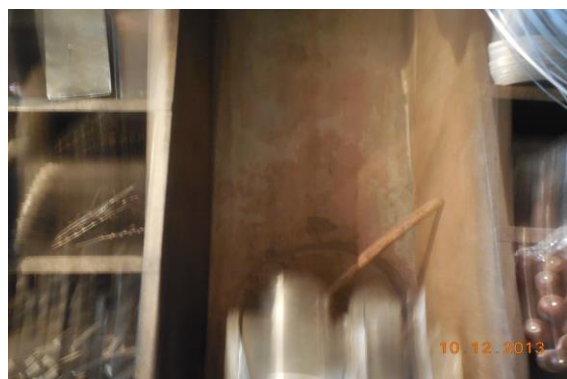
Photo 46

Peeling of Plaster on Right side Wall of Shop No. 299 of Ground Floor

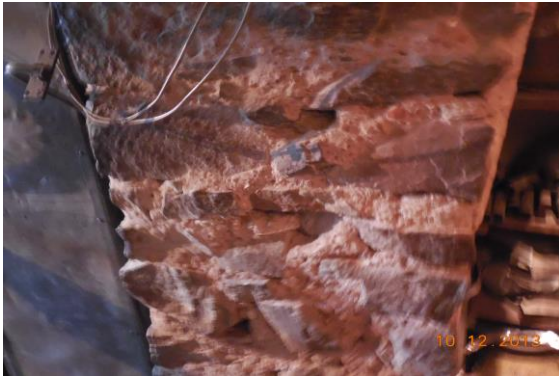
Photo 47

Dampness/Seepage on Wall No. 1 of Part B of Shop No. 299, Ground Floor

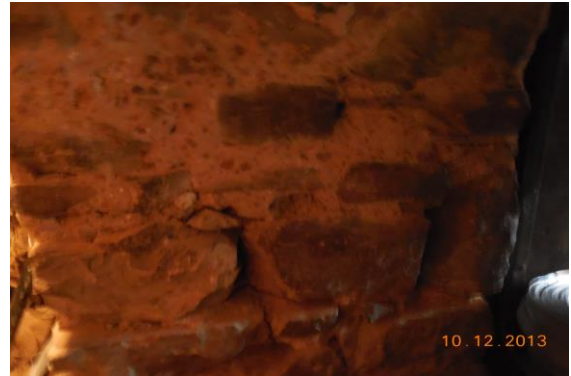
Photo 48
Peeling of Plaster on Part C of Shop No. 299, Ground Floor

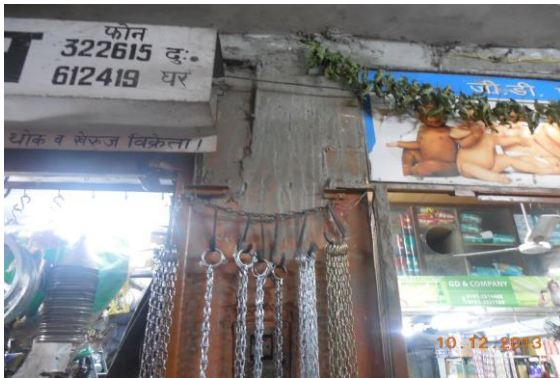
Photo 53
Peeling of Plaster on Wall No. 1 of Part A of Shop No. 299, Ground Floor

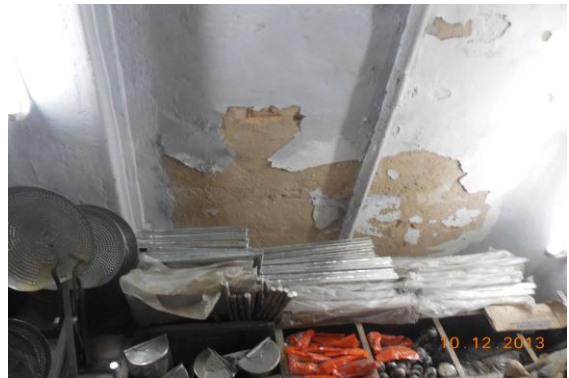
Photo 54

Peeling of Plaster on Front Side Wall of Shop No. 300 of Ground Floor

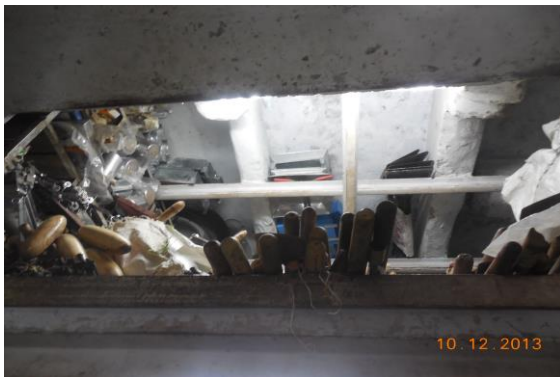
Photo 55

Peeling of Plaster on Roof of Shop No. 300 of Ground Floor

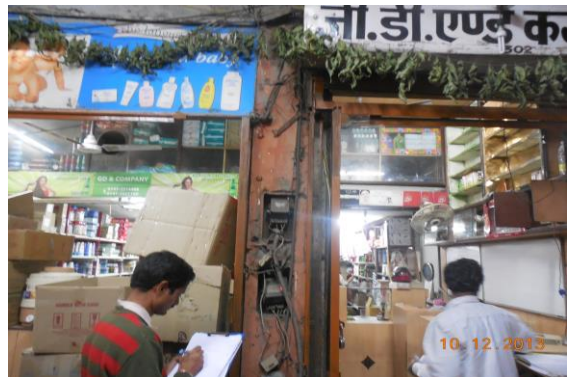
Photo 56

37	Shop No. 300 Ground Floor	Dampness/Seepage	56
38	Wall No. 3 & Outer wall Shop No. 301 & 302 Ground Floor	Damaged Portion	57

Dampness/Seepage of Shop No. 300 of Ground Floor

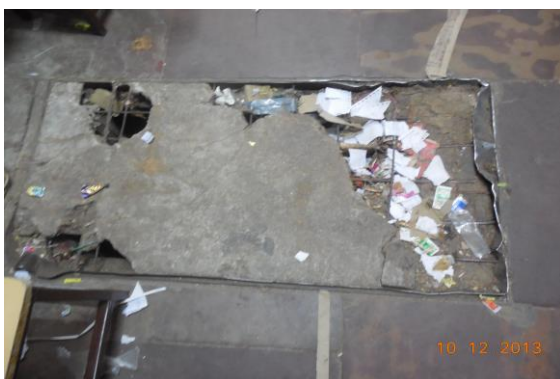
Photo 57

Damaged Portion on Wall No. 3 & Outer wall of Shop No. 301 & 302 of Ground Floor

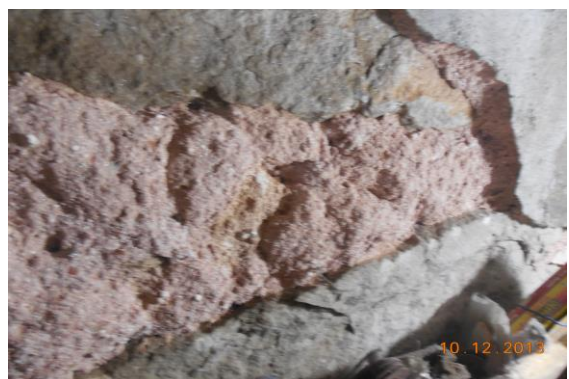
Photo 58

Damaged Portion on Floor of Varanda of Shop No. 301 & 302, Ground Floor

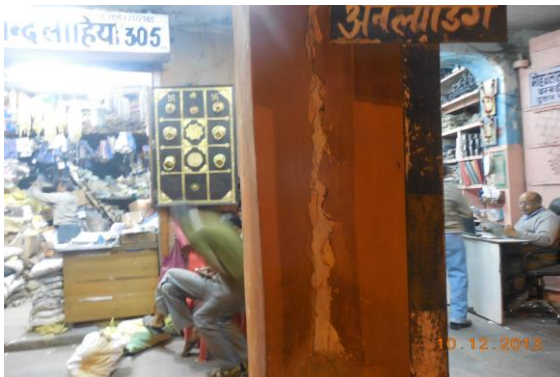
Photo 61
Damaged Portion on Right side External Beam of Shop No. 305 of Ground Floor

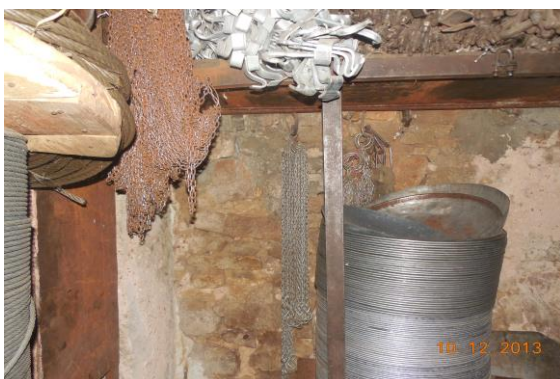
Photo 63
Peeling of Plaster on Roof of Shop No.307 of Ground Floor

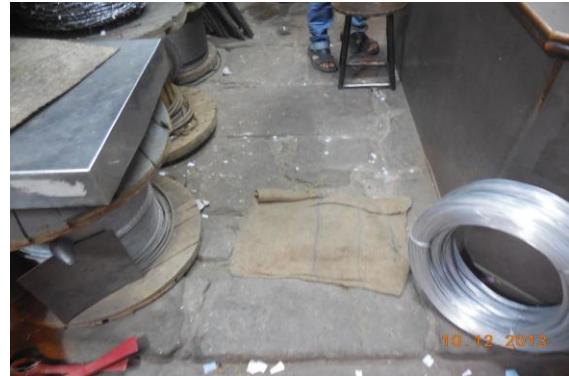
Photo 67
Peeling of Plaster on Floor of Shop No. 308 of Ground Floor

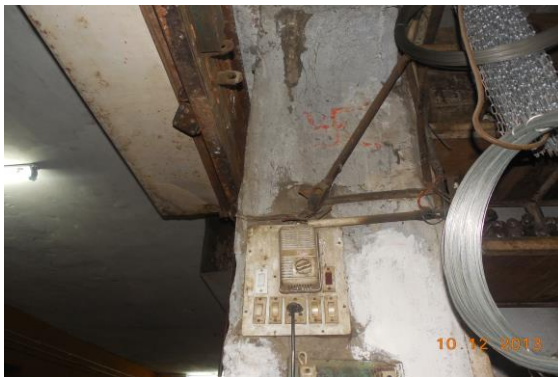
Photo 68
Peeling of Plaster on Roof of Part A of Shop No. 308, Ground Floor

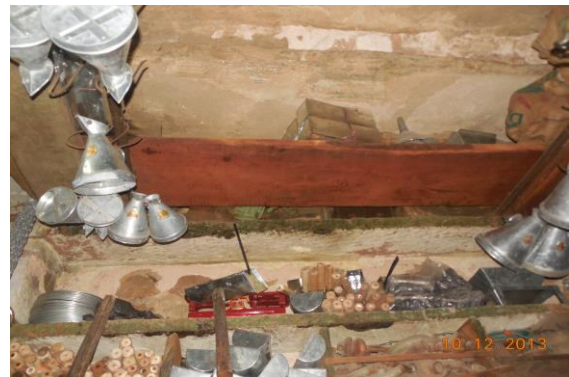
Photo 69
Peeling of Plaster on Roof of Part B of Shop No. 308, Ground Floor

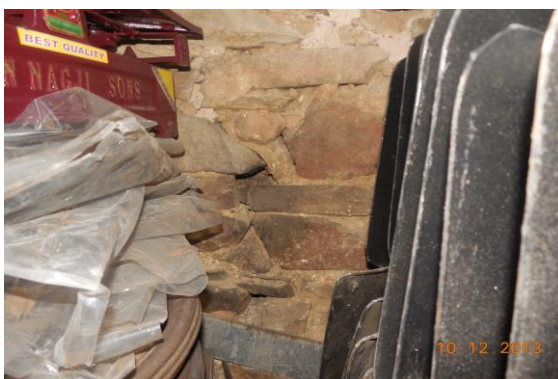
Photo 70
Peeling of Plaster on Wall No. 1 of Part B of Shop No. 308, Ground Floor

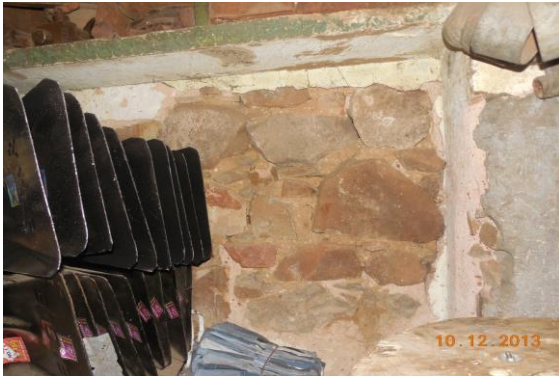
Photo 72

Peeling of Plaster on Wall No. 1 of Part D of Shop No. 308, Ground Floor

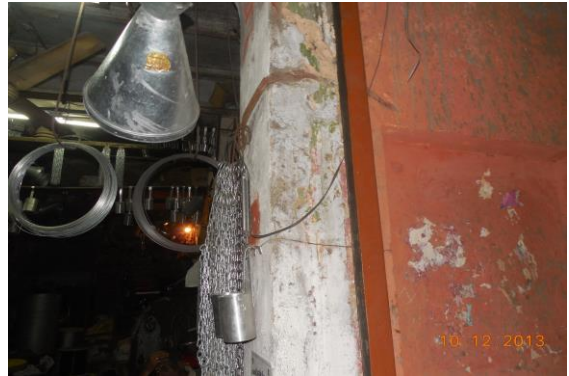
Photo 73

Peeling of Plaster on Wall No. 3 & Outer wall of shop of Varanda of Shop No. 308, Ground Floor

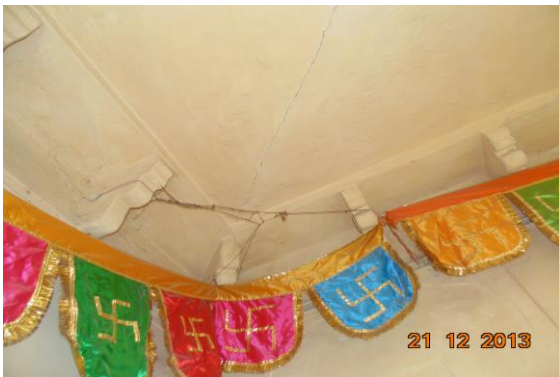
Photo 74

Peeling of Plaster on Wall No. 2, 3 & Shade of Open Sky of Ground Floor

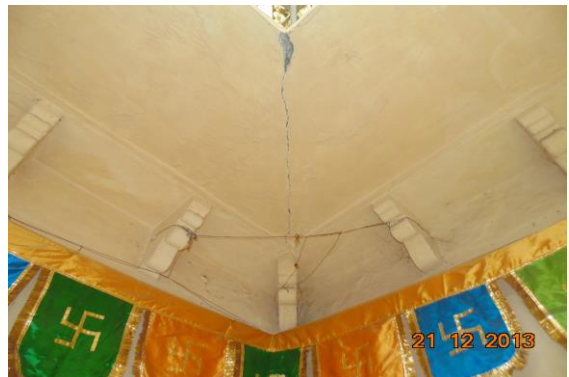
Photo 75

Peeling of Plaster on Wall No. 2, 4 & Shade of Open Sky of Ground Floor

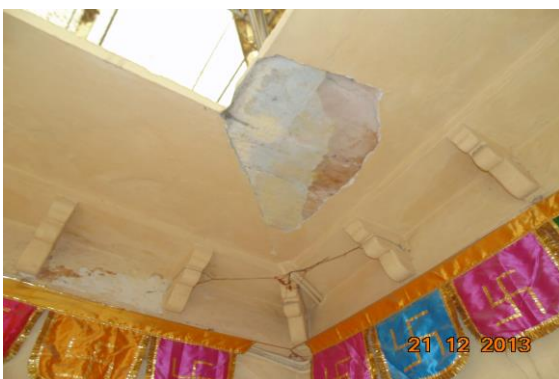
Photo 76

Peeling of Plaster on Wall No. 1 & Shade of Open Sky of Ground Floor

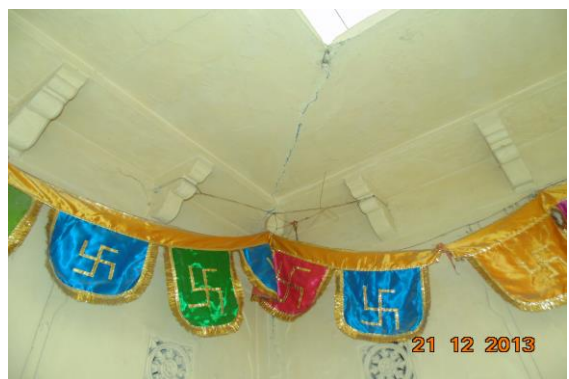
Photo 77

Peeling of Plaster on Wall No. 1 & 2 of Open Sky of Ground Floor

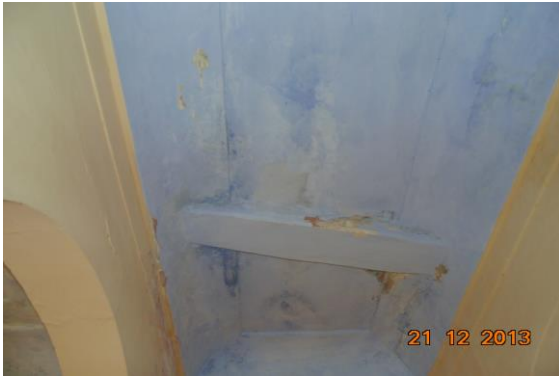
Photo 78
Dampness/Seepage on Roof of Varanda of Ground Floor

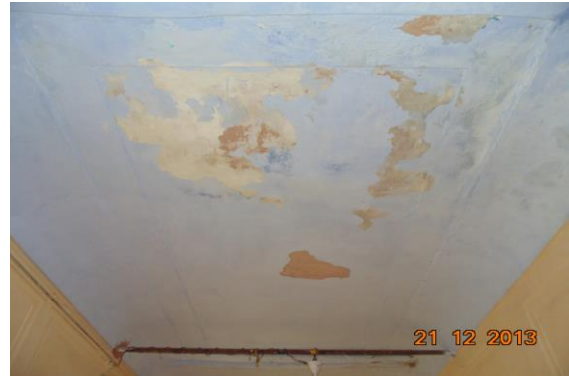
Photo 79
Dampness/Seepage on Roof of Varanda of Ground Floor

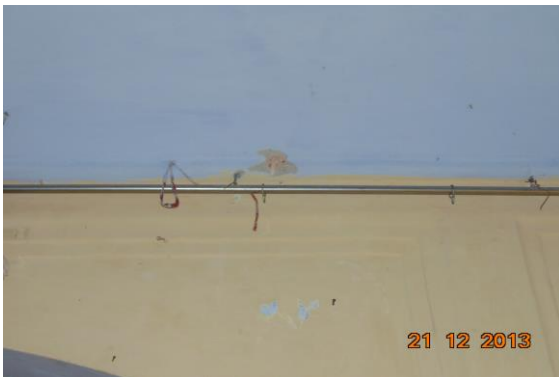
Photo 80
Peeling of Plaster on Wall No. 2 of Varanda No.2 of Ground Floor

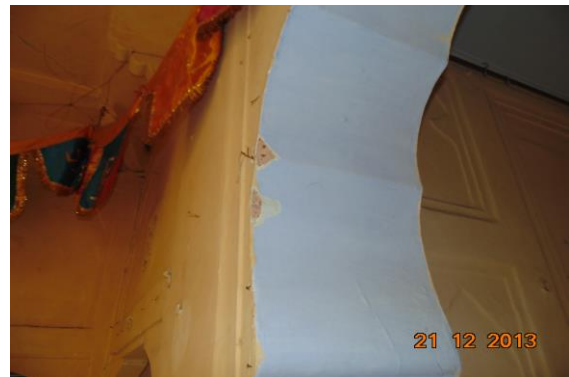
Photo 81
Peeling of Plaster on Wall No. 3 & Outer Wall of Varanda No.2 of Ground Floor

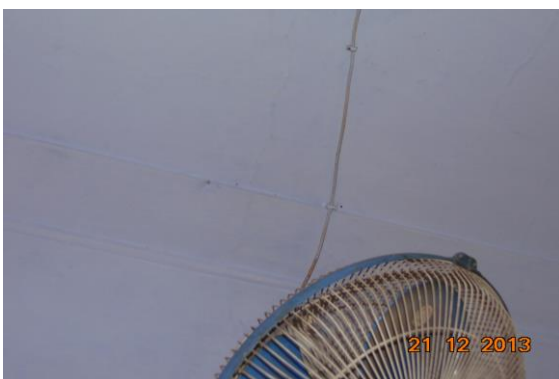
Photo 82
Peeling of Plaster on Roof of Passage No.1 of Ground Floor

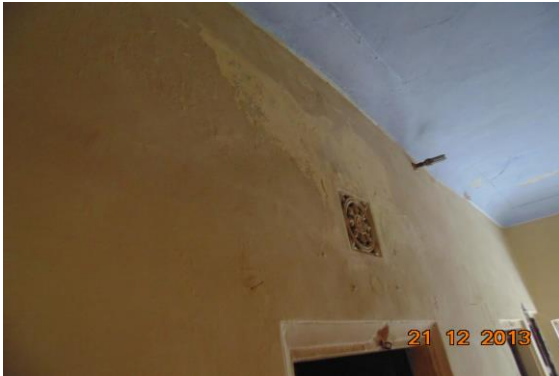
Photo 84

Dampness/Seepage on Wall No. 1 of Passage No.1 of Ground Floor

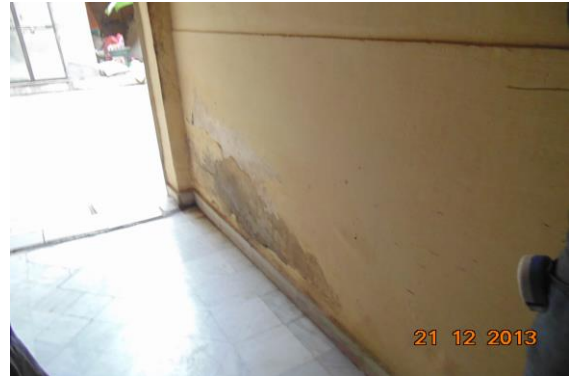
Photo 85

Dampness/Seepage on Wall No. 2 of Passage No.1 of Ground Floor

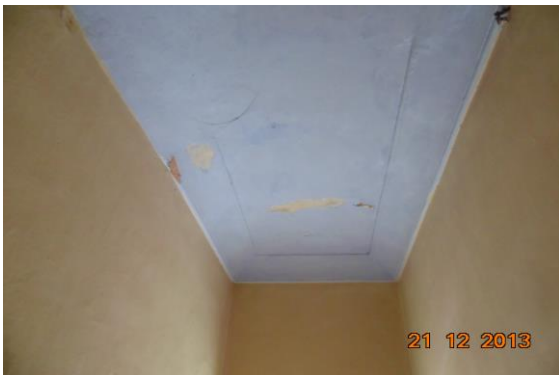
Photo 86

Peeling of Plaster on Roof of Passage No.1 of Ground Floor

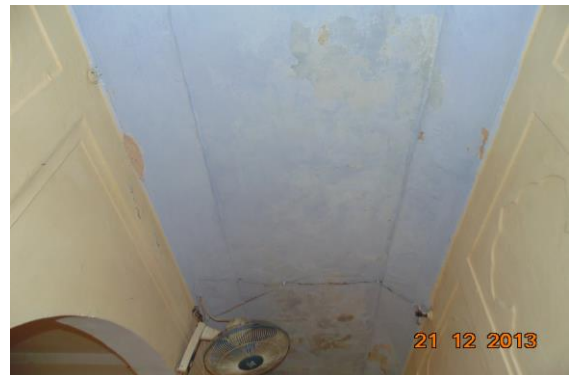
Photo 87

Dampness/Seepage on Roof of Passage No.2 of Ground Floor

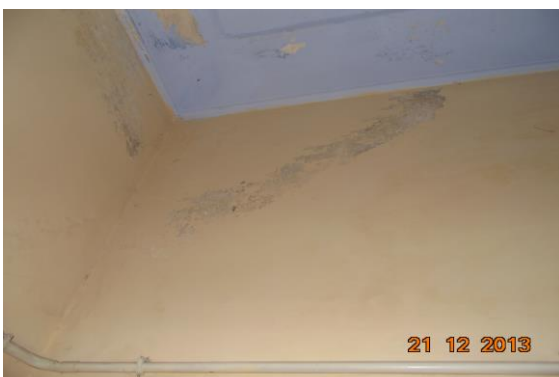
Photo 88

Peeling of Plaster on Wall No. 1 of Passage No.2 of Ground Floor

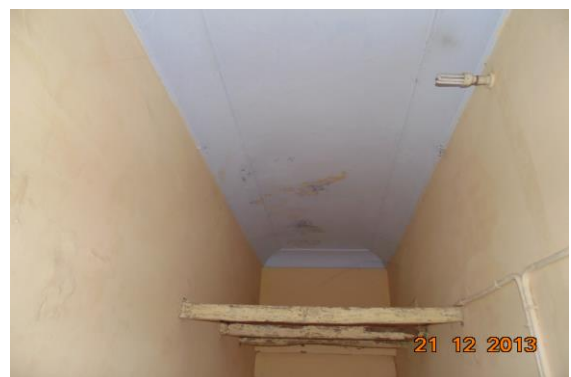
Photo 89

Peeling of Plaster on Roof of Passage No.2 of Ground Floor

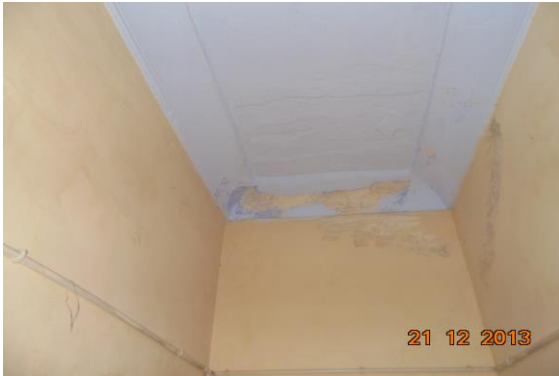
Photo 90
Peeling of Plaster on Roof of Passage No.2 of Ground Floor

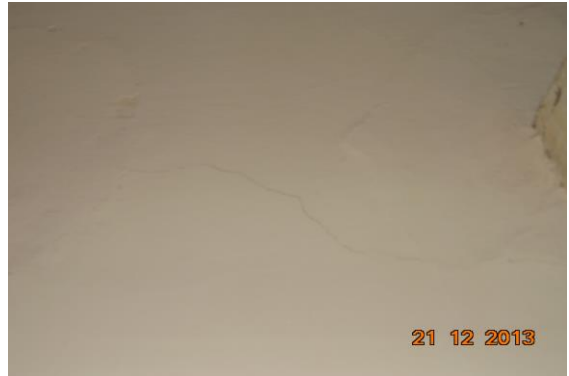
Photo 91
Peeling of Plaster on Wall No. 2 of Passage No.2 of Ground Floor

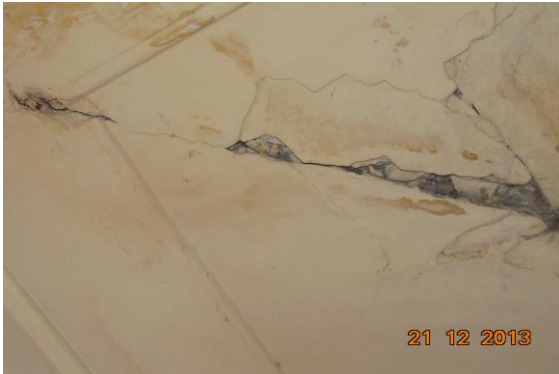
Photo 92
Peeling of Plaster on Wall No. 1 & Shade of Passage No.3 of Ground Floor

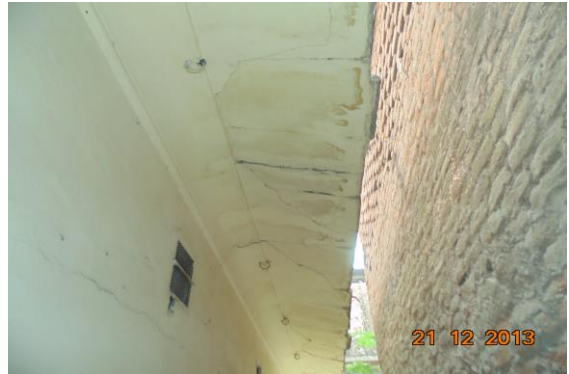
Photo 93
Peeling of Plaster on Wall No. 1 & Shade of Passage No.3 of Ground Floor

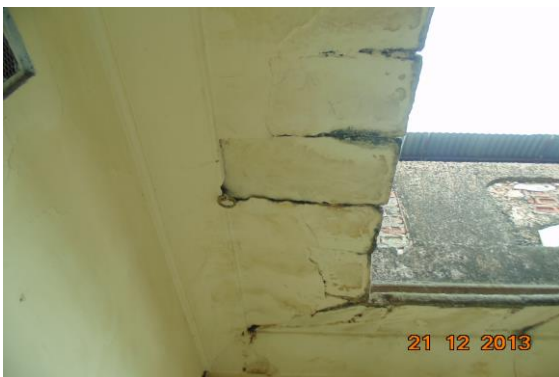
Photo 94
Peeling of Plaster on Wall No. 1 & Shade of Passage No.3 of Ground Floor

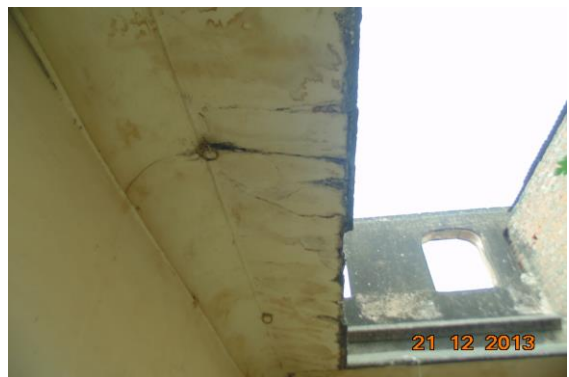
Photo 95
Peeling of Plaster on Wall No. 1 & Shade of Open Sky of Ground Floor

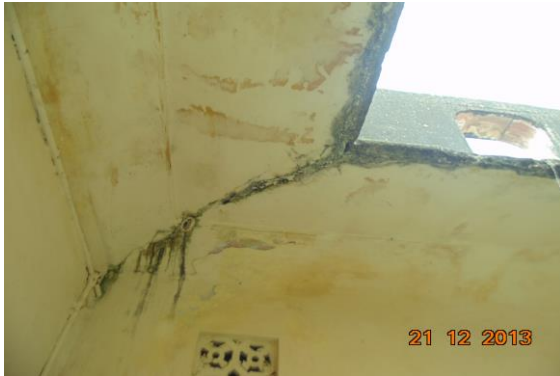
Photo 96

Peeling of Plaster on Wall No. 1 & Shade of Open Sky of Ground Floor

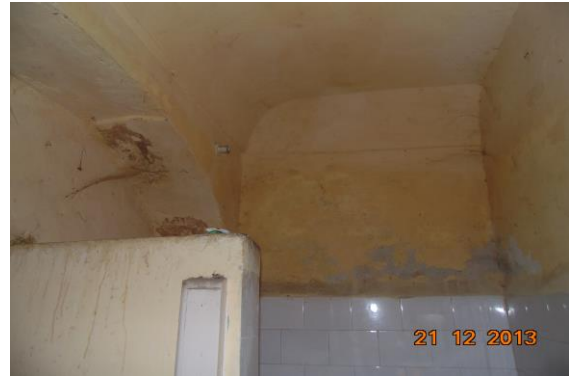
Photo 97

Dampness/Seepage on Wall No. 4 of Bathroom of Temple, Ground Floor
