Pre Building Condition Survey Report

Name and Address of Structure :	Choti Chopar to Badi Chopar (Down Line)
---------------------------------	---

Name of the Project	Contract JMRC-UG1B “Design and Construction of Tunnel between Chandpole and Badi Chouper and reverse line by Shield TBM, Underground Metro Stations at Choti Chouper and Badi Chouper by Cut and Cover Methods on East West Corridor of Jaipur Metro Rail Corporation Limited .”	
Owner :

Pre Building Condition Survey Report Choti Chopar to Badi Chopar (Down Line)

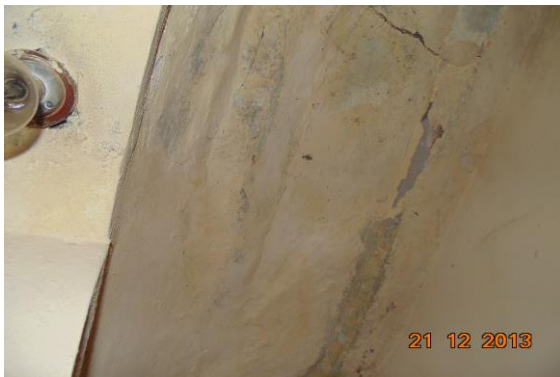
Photo 98

Dampness/Seepage on Roof of Bathroom of Temple, Ground Floor

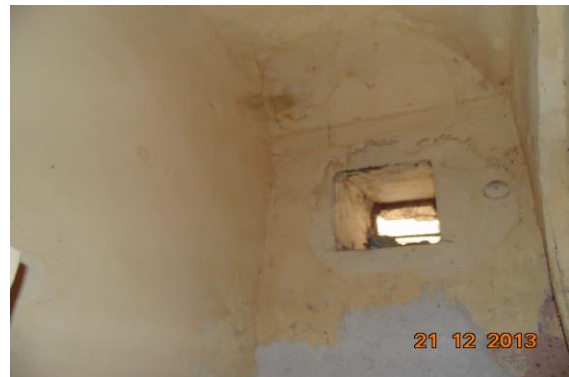
Photo 99

Dampness/Seepage on Wall No. 1, 4, 2 & Roof of Toilet No. 1 of Temple, Ground Floor

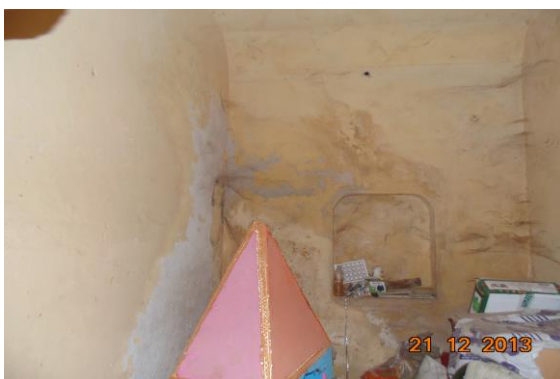
Photo 100

Dampness/Seepage on Wall No. 1 & 4 of Store No.1 of Ground Floor

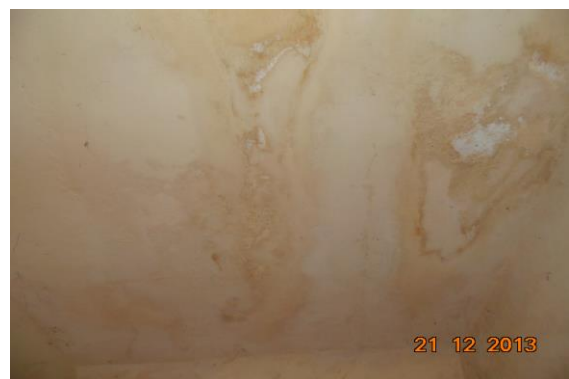
Photo 101

Dampness/Seepage on Roof of Store No.1 of Ground Floor

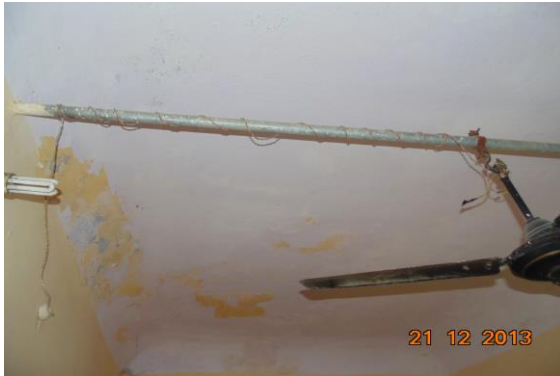
Photo 102
Dampness/Seepage on Roof of Room No. 3 of Temple, Ground Floor

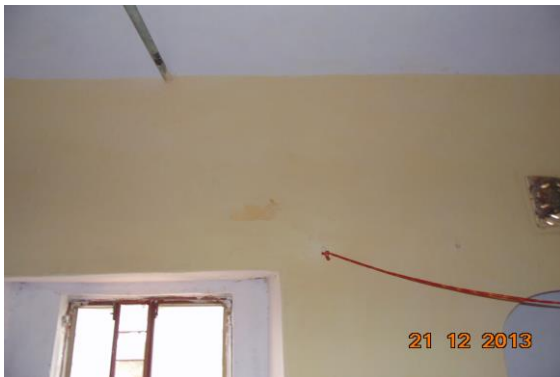
Photo 104
Peeling of Plaster on Wall No. 4 of Room No. 3 of Temple, Ground Floor

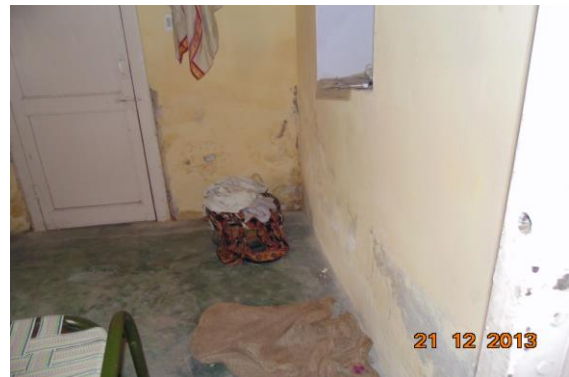
Photo 105
Dampness/Seepage on Wall No. 2 & 3 of Room No. 3 of Temple, Ground Floor

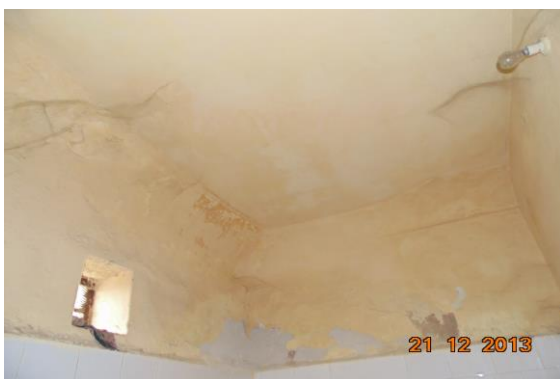
Photo 106
Dampness/Seepage on Wall No. 2, 4 & Roof of Toilet No. 1 of Temple, Ground Floor

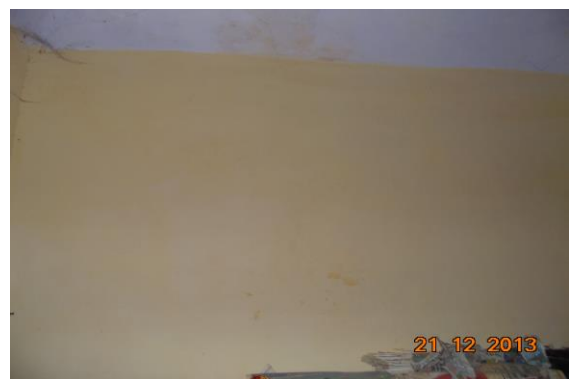
Photo 107
Dampness/Seepage on Wall No. 1 of Toilet No. 1 of Temple, Ground Floor

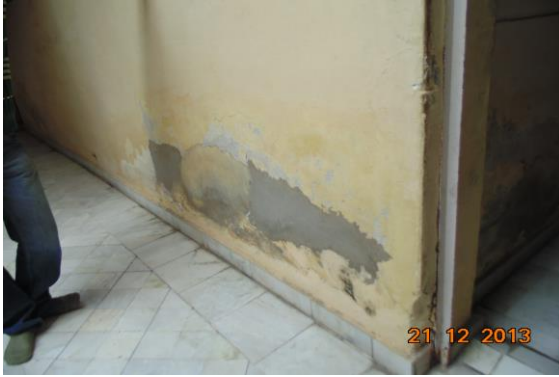
Photo 108
Peeling of Plaster on Wall No. 3 of Open Sky No.2 of Ground Floor

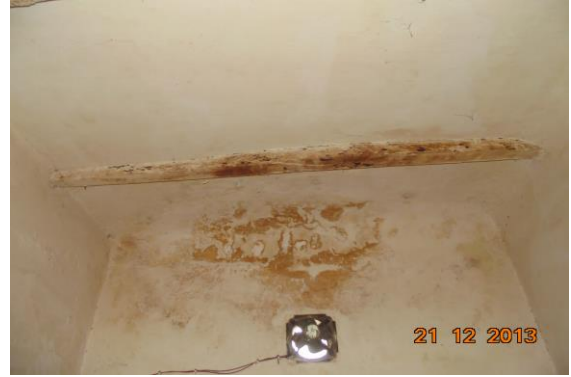
Photo 109
Dampness/Seepage on Wall No. 4 & roof of Room No. 2 of Temple, Ground Floor

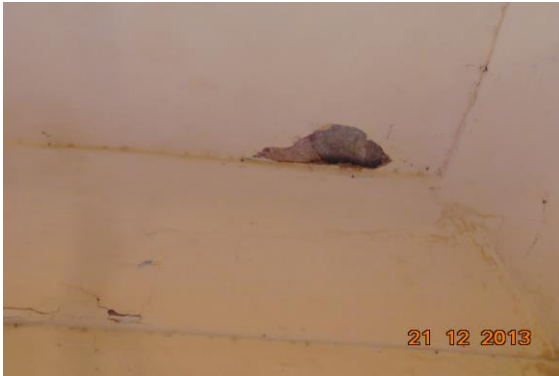
Photo 110
Peeling of Plaster on Roof of Room No. 5 of Temple, Ground Floor

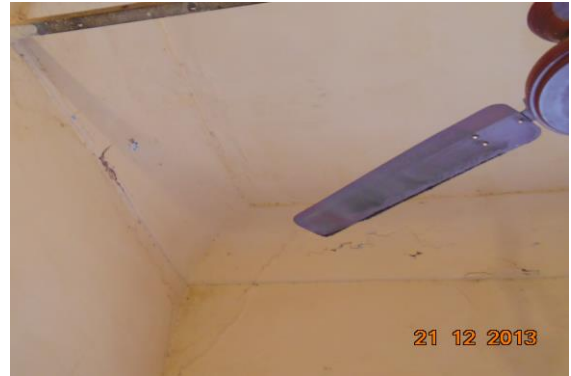
Photo 111
Peeling of Plaster on Roof of Room No. 5 of Temple, Ground Floor

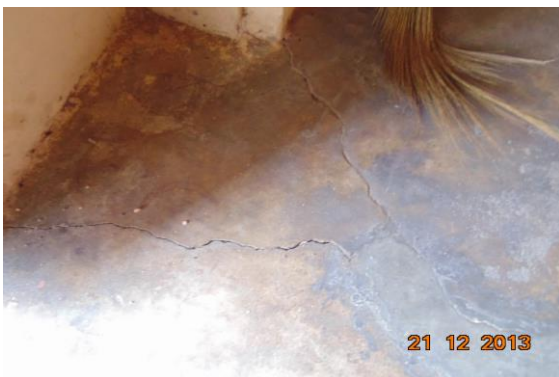
Photo 112
Peeling of Plaster on Floor of Room No. 5 of Temple, Ground Floor

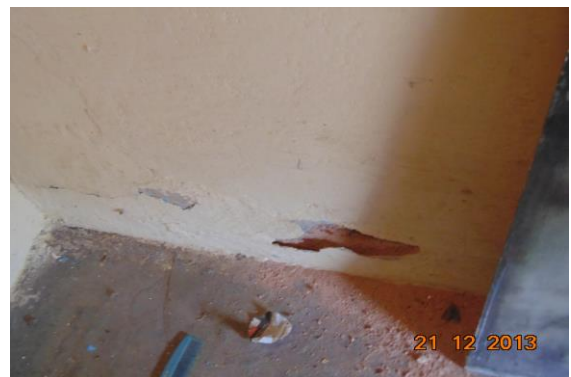
Photo 113
Peeling of Plaster on Wall No. 1 of Room No. 5 of Temple, Ground Floor

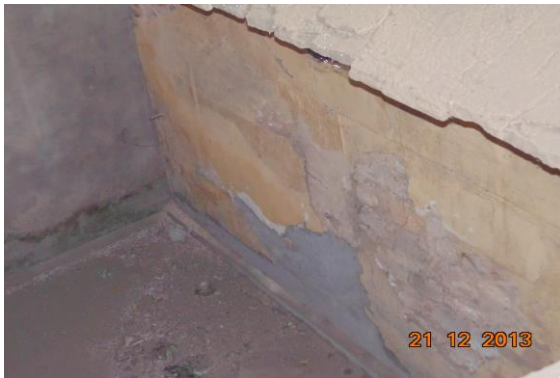
Photo 114

Peeling of Plaster on Wall No. 1, Shade & Tinshed of Temple of Ground Floor

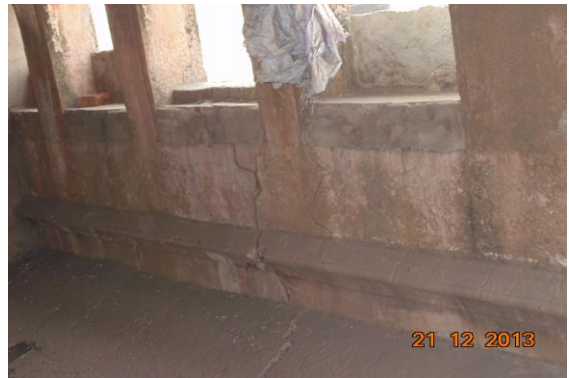
Photo 115

Peeling of Plaster on Wall No. 1, Shade & Tinshed of Temple of Ground Floor

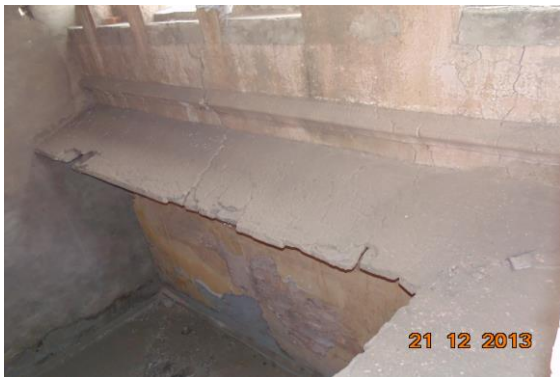
Photo 116

Peeling of Plaster on Wall No. 1, Shade & Tinshed of Temple of Ground Floor

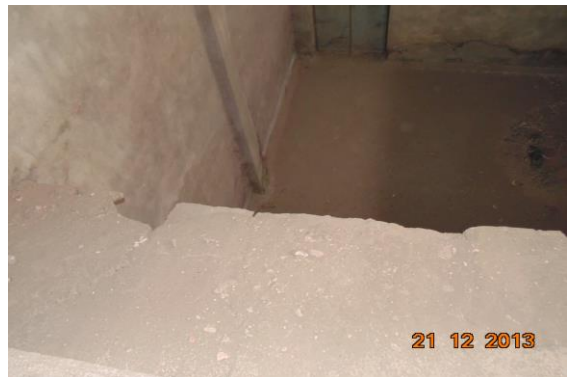
Photo 117

Peeling of Plaster on Wall No. 1, Shade & Tinshed of Temple of Ground Floor

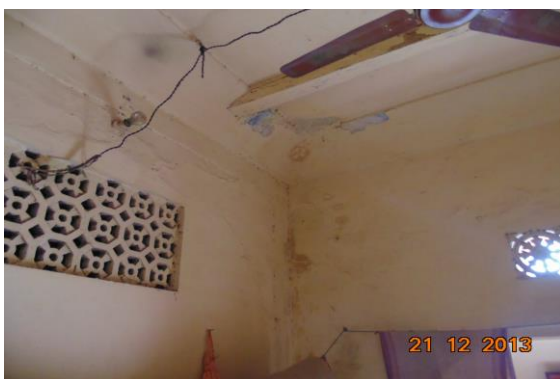
Photo 118

Dampness/Seepage on Wall No. 1, 4 & Roof of Room No. 6 of Temple, Ground Floor

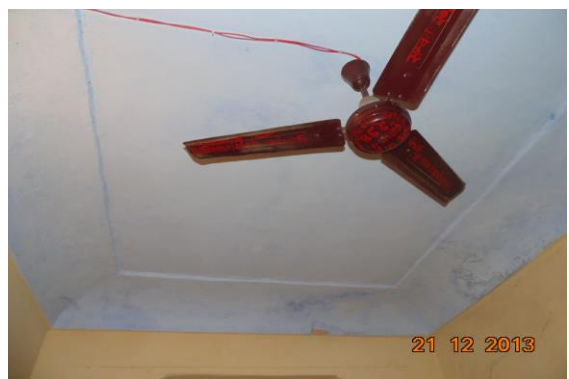
Photo 119

Dampness/Seepage on Roof of Room No. 7 of Temple, Ground Floor

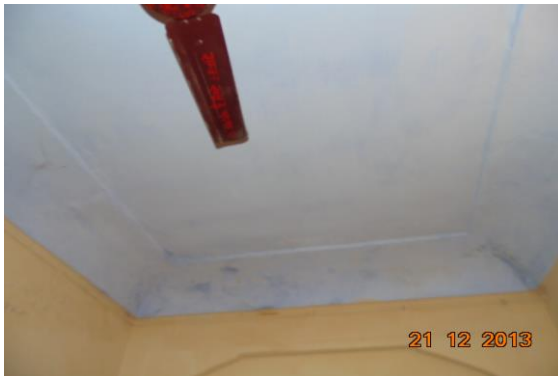
Photo 120
Dampness/Seepage on Roof of Room No. 7 of Temple, Ground Floor

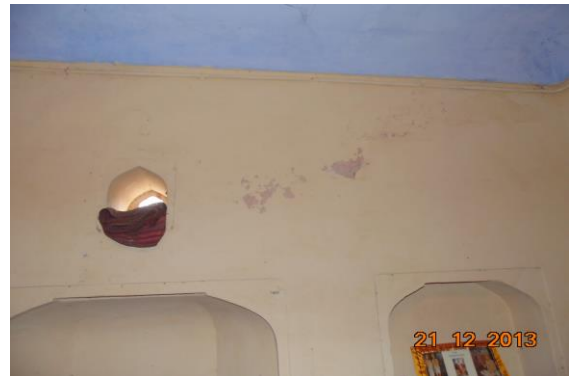
Photo 121
Dampness/Seepage on Wall No. 4 of Room No. 7 of Temple, Ground Floor

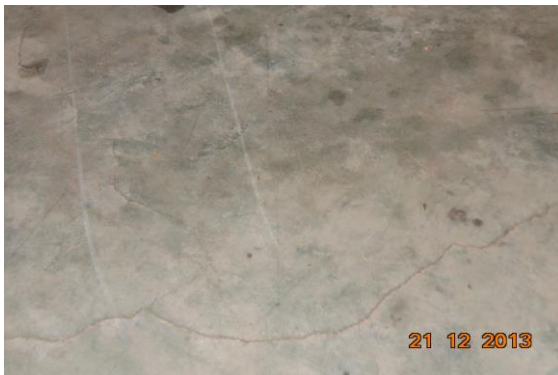
Photo 122
Peeling of Plaster on Floor of Room No. 7 of Temple, Ground Floor

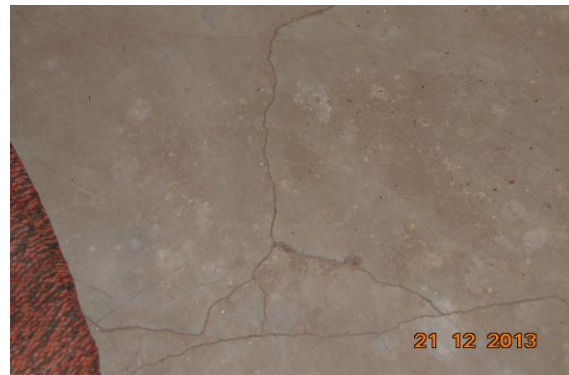
Photo 123
Peeling of Plaster on Floor of Room No. 7 of Temple, Ground Floor

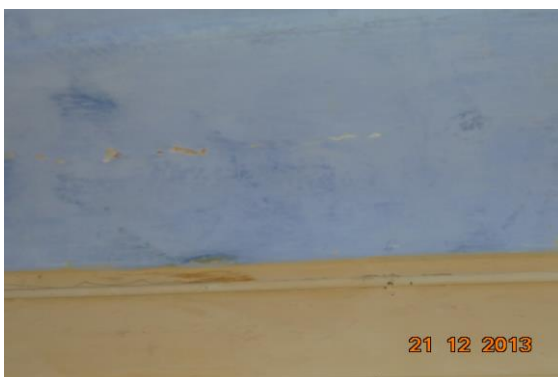
Photo 124
Peeling of Plaster on Roof of Room No. 7 of Temple, Ground Floor

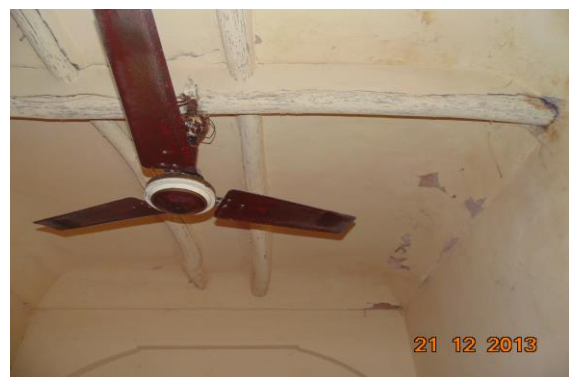
Photo 125
Dampness/Seepage on Roof of Room No. 1 of Temple, Ground Floor

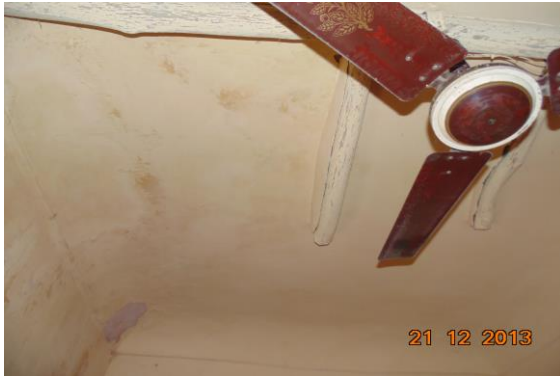
Photo 126
Dampness/Seepage on Roof of Room No. 1 of Temple, Ground Floor

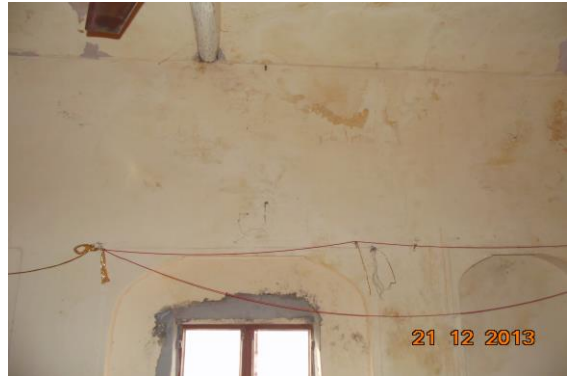
Photo 127
Dampness/Seepage on Wall No. 4 of Room No. 1 of Temple, Ground Floor

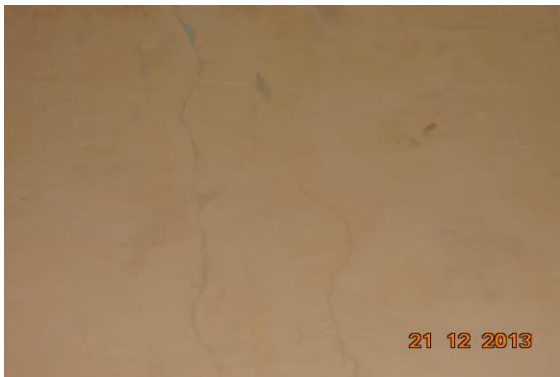
Photo 128
Peeling of Plaster on Wall No. 4 of Room No. 1 of Temple, Ground Floor

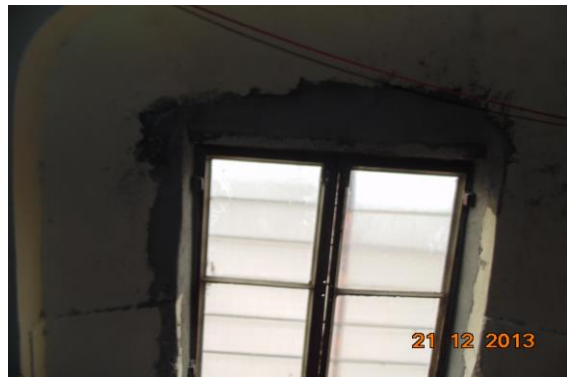
Photo 129
Peeling of Plaster on Wall No. 4 of Room No. 1 of Temple, Ground Floor

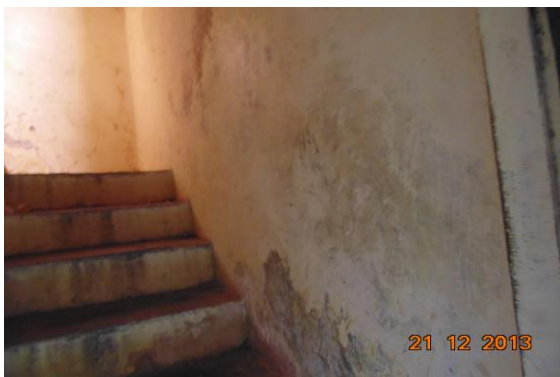
Photo 130
Dampness/Seepage on Wall No. 2 of Staircase of Ground Floor

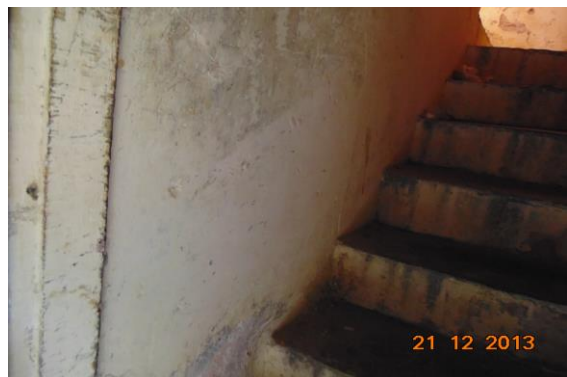
Photo 131
Dampness/Seepage on Wall No. 1 of Staircase of Ground Floor

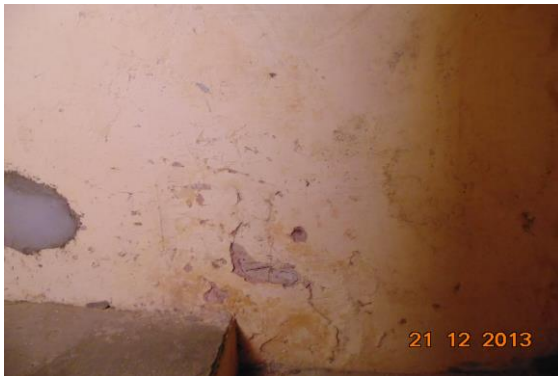
Photo 132
Peeling of Plaster on Wall No. 4 of Staircase of Ground Floor

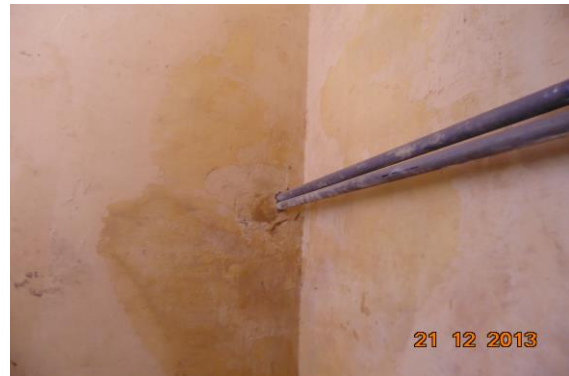
Photo 133
Dampness/Seepage on Wall No. 4 of Staircase of Ground Floor

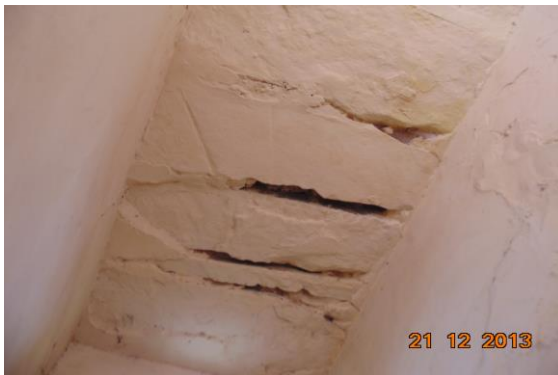
Photo 134
Peeling of Plaster on Roof of Staircase of Ground Floor

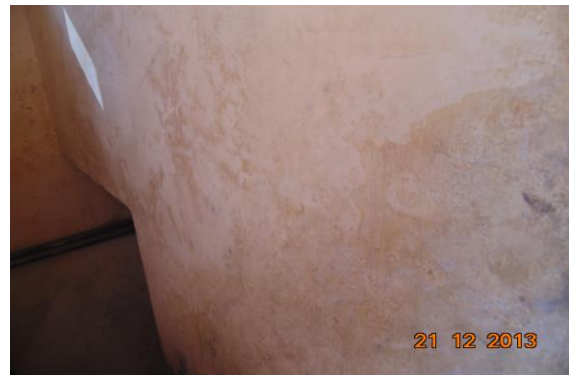
Photo 135
Dampness/Seepage on Wall No. 1 of Staircase of Ground Floor

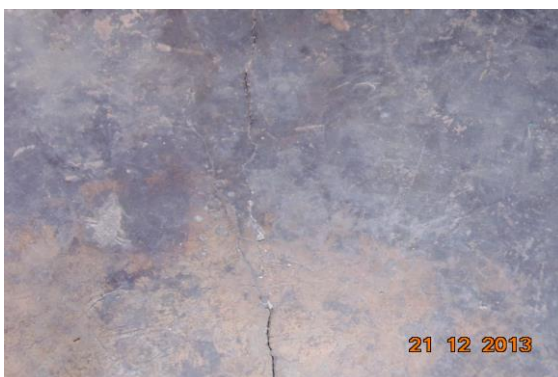
Photo 136
Peeling of Plaster on Floor of Hall No. 1 of Temple, Ground Floor

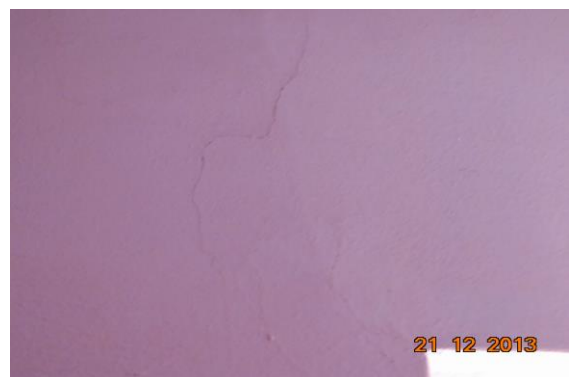
Photo 137
Peeling of Plaster on Wall No. 3 of Hall No. 1 of Temple, Ground Floor

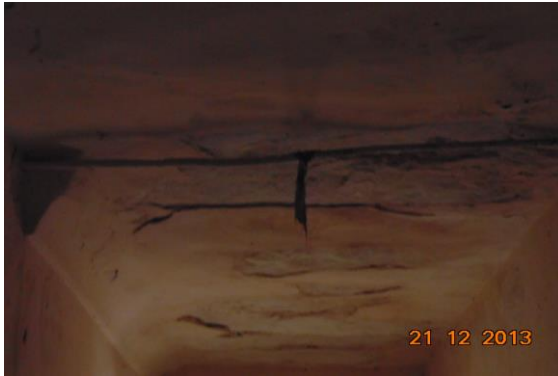
Photo 138

Peeling of Plaster on Roof of Room No. 1 of Temple, Ground Floor

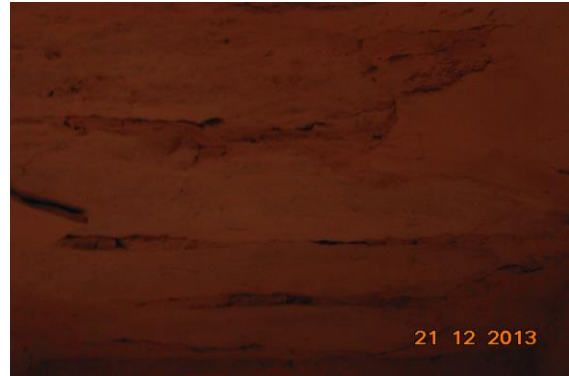
Photo 139

Peeling of Plaster on Roof of Room No. 1 of Temple, Ground Floor

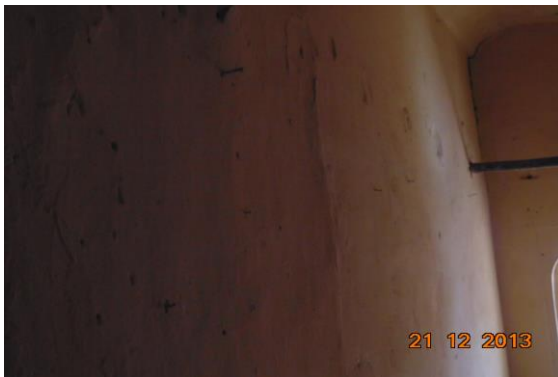
Photo 140

Dampness/Seepage on Wall No. 3 of Room No. 1 of Temple, Ground Floor

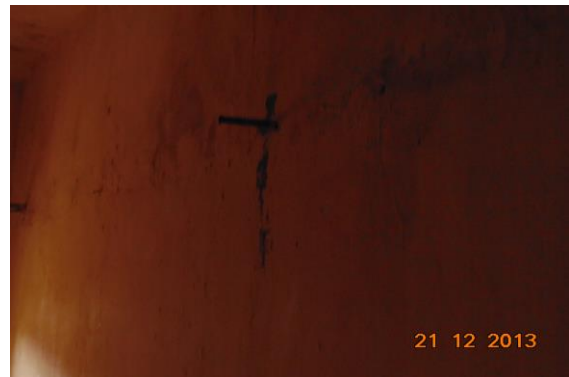
Photo 141

Dampness/Seepage on Wall No. 4 of Room No. 1 of Temple, Ground Floor

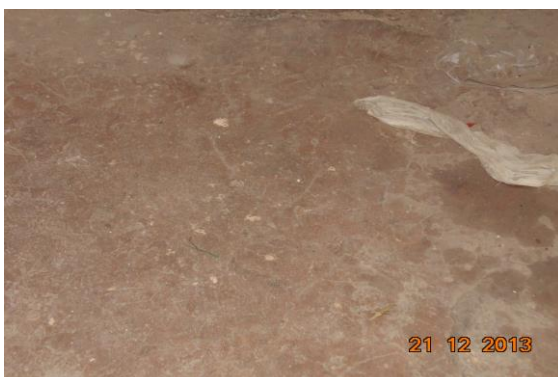
Photo 142

Peeling of Plaster on Floor of Room No. 1 of Temple, Ground Floor

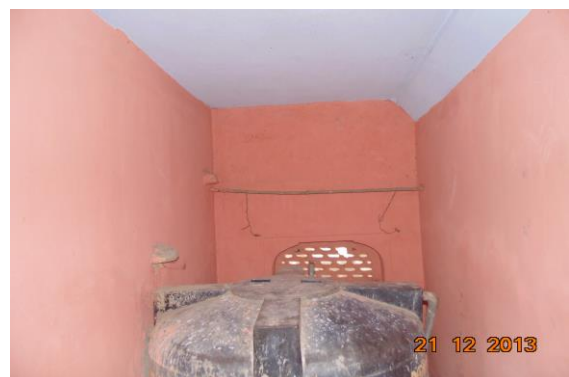
Photo 143

Dampness/Seepage on Wall No. 1 of Room No. 2 of Temple, Ground Floor

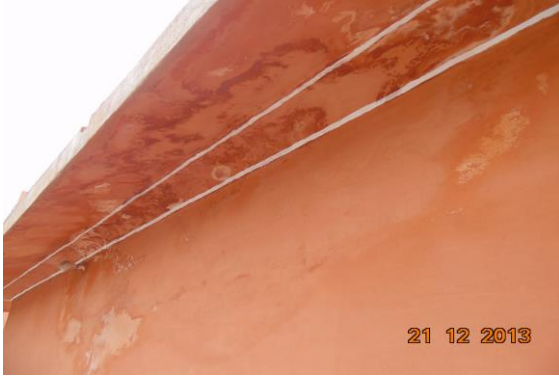
Photo 144

Dampness/Seepage on Wall No. 2 of Room No. 1 of Temple, Ground Floor

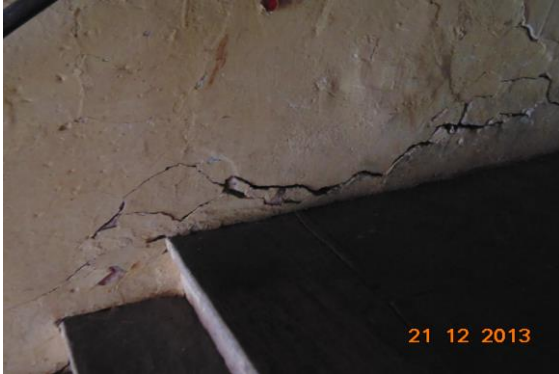
Photo 146

Damaged Portion on Wall No. 1 of Stair GF to Terrace of Temple, Ground Floor

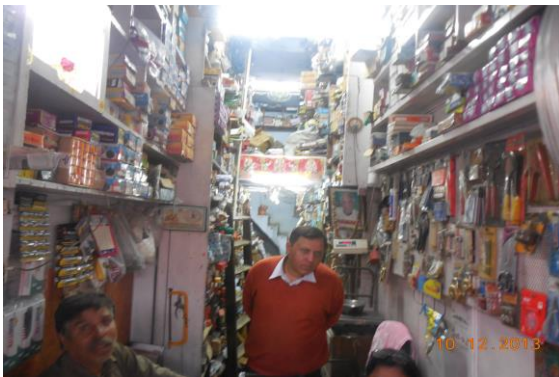
Photo 147

Shop No. 296 of Ground Floor View of Shop No.296

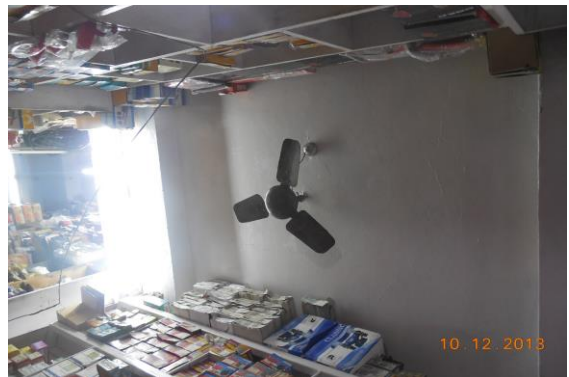
Photo 148

Wall No. 1 & 2 of Shop No. 297 of Ground Floor Covered With Material

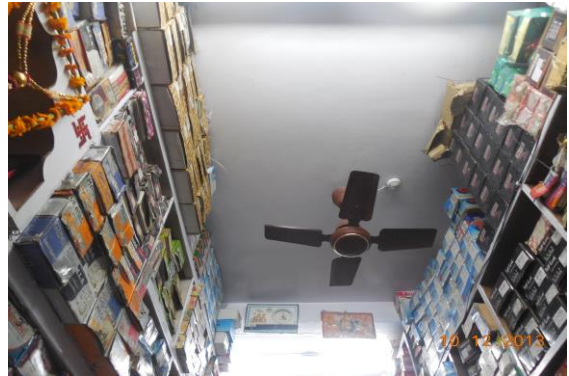
Photo 150

Wall No. 1, 2 & 4 of Shop No. 297A of Ground Floor Covered with Material

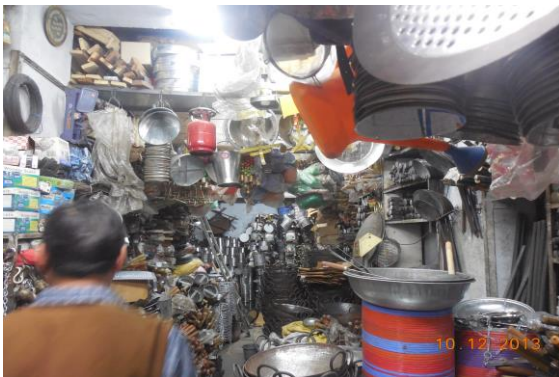
Photo 151

Roof of Shop No. 297A of Ground Floor Covered With Falls Ceiling

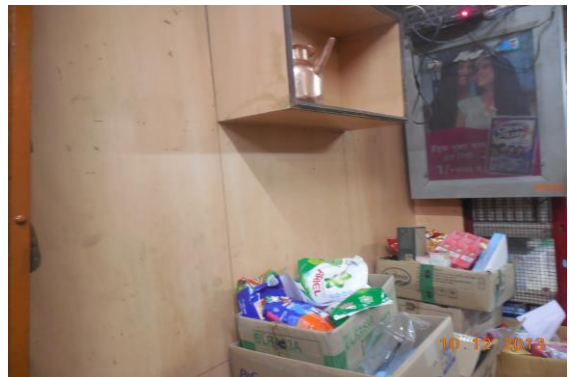
Photo 152

Wall No. 1, 2 & 4 of Shop No. 300 of Ground Floor Covered With Material

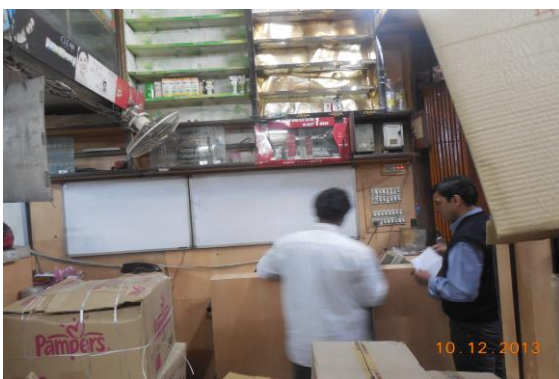
Photo 153

Wall No. 1 of Shop No. 301 & 302 of Ground Floor Covered With material

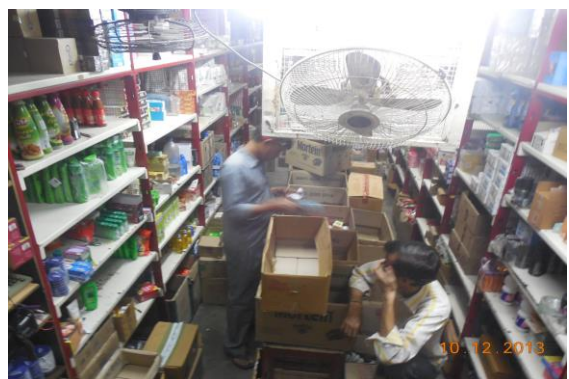
Photo 154

Wall No. 2 of Shop No. 301 & 302 of Ground Floor Covered With material

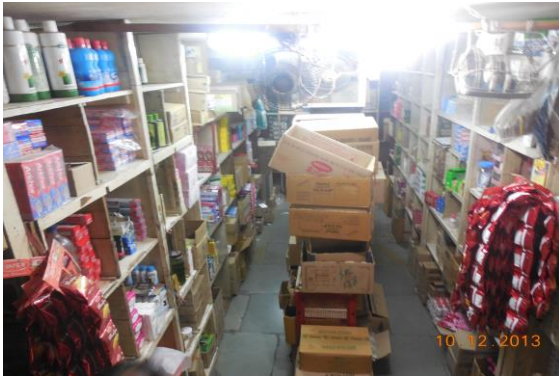
Photo 155

All Walls of Shop No. 301 & 302 of Basement No. 1 Covered With material

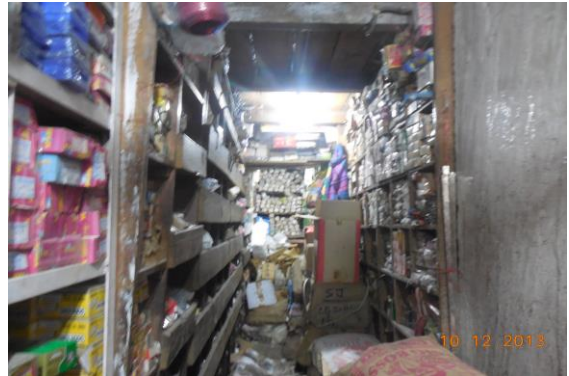
Photo 156

All Walls of Shop No. 301 & 302 of Basement No. 2 Covered With material

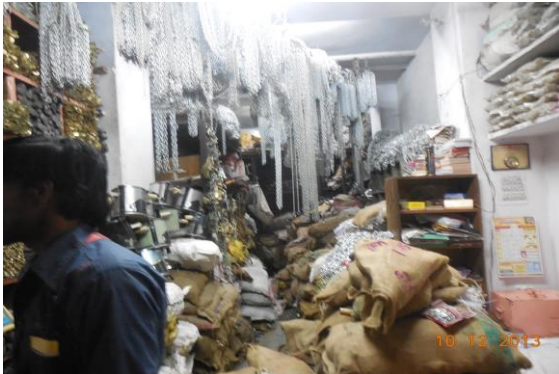
Photo 157

Wall No. 1, 2 & 4 of Shop No. 302A of Ground Floor Covered with material

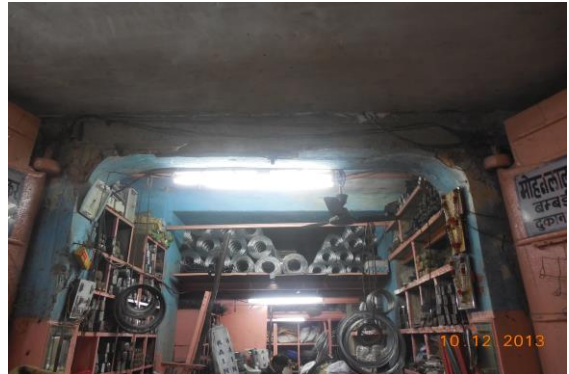
Photo 158

All Walls of Shop No. 304 of Ground Floor Covered With steel Items

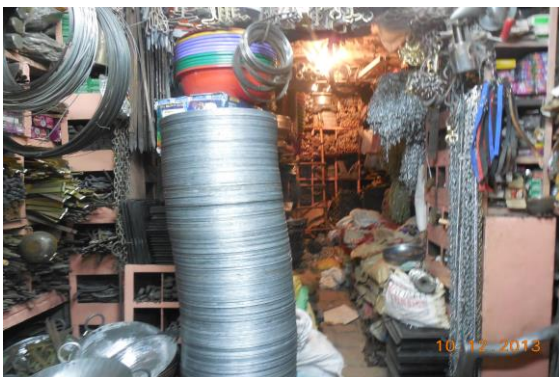
Photo 159

Shop No. 305 of Ground Floor Not permitted

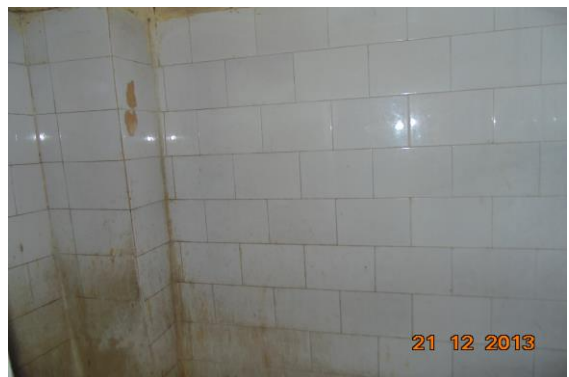
Photo 160

Wall No. 1, 2 & 3 of Shop No.307 of Ground Floor Covered With material

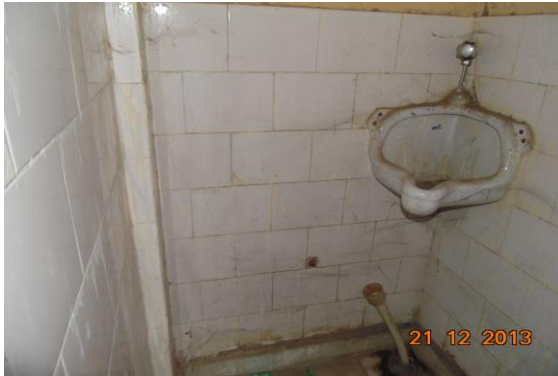
Photo 161

All Walls of Bathroom of Temple, Ground Floor Half covered With Tiles

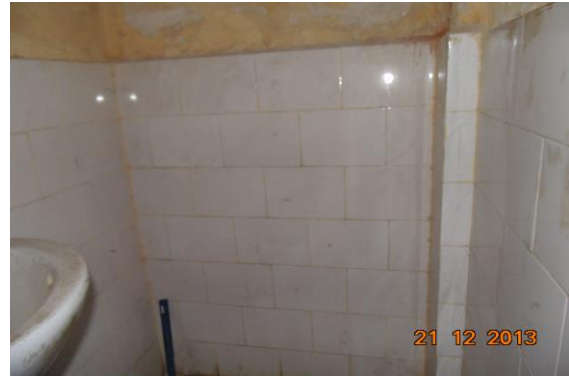
Photo 162

All Walls of Bathroom of Temple, Ground Floor Half covered With Tiles

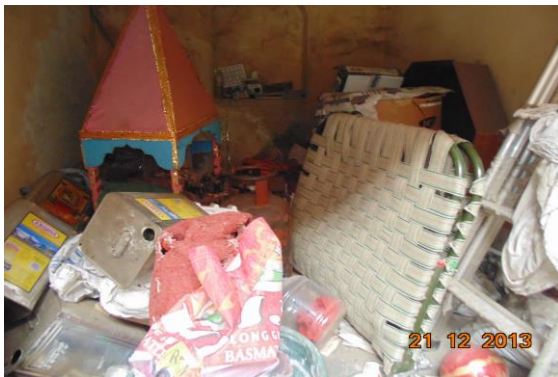
Photo 163

All Walls of Toilet No. 1 of Temple, Ground Floor Bottom Covered With Tiles

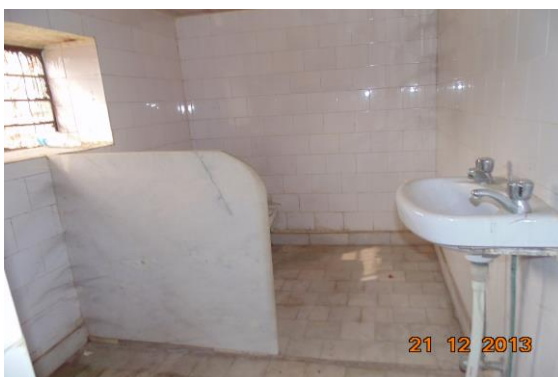
Photo 165

Room No. 4 of Temple, Ground Floor Locked

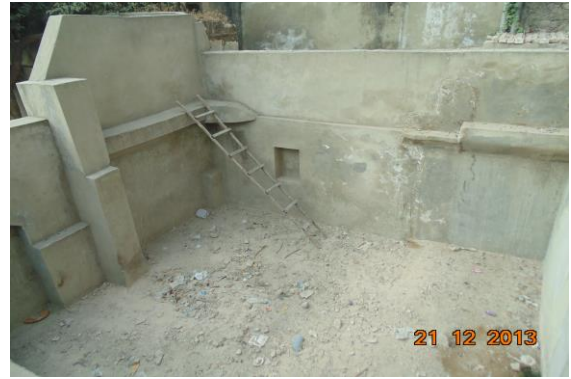
Photo 168

Wall No. 2 of Temple of Ground Floor Covered With material

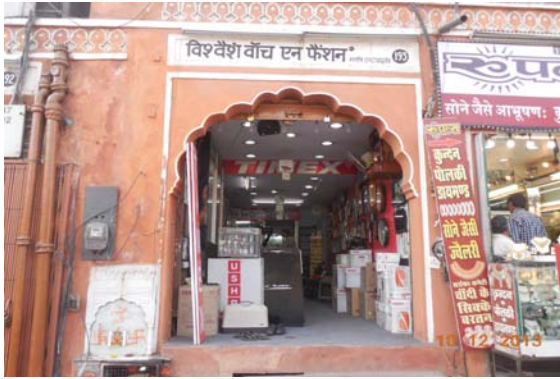
Photo 1
View of Shop No. 193

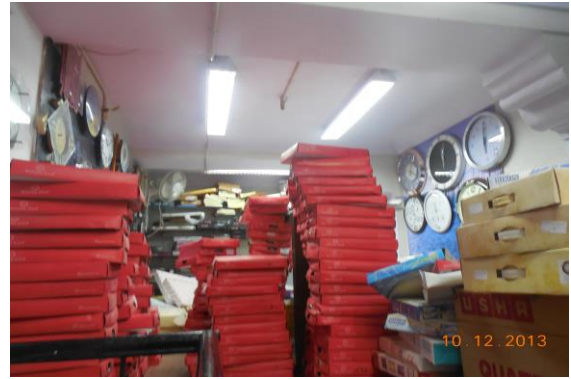
Photo 2
View of Upper Ground Floor, Ground Floor

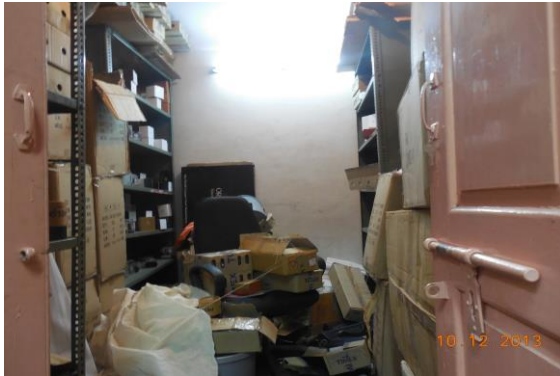
Photo 3
View of Upper Ground Floor, Ground Floor

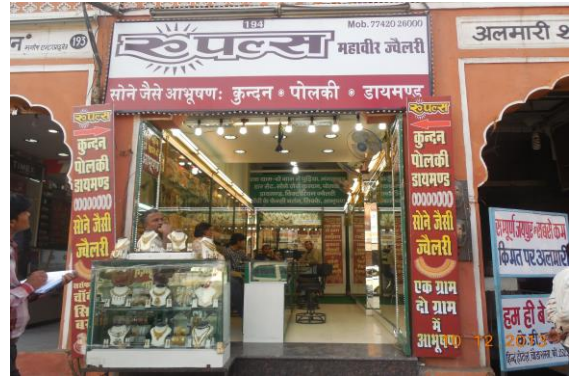
Photo 4
Not Permitted, Ground Floor

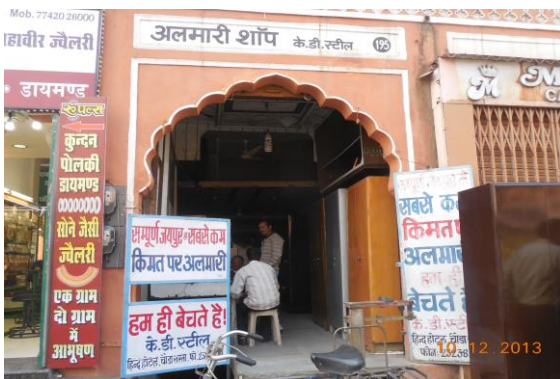
Photo 5
Not Permitted, Ground Floor

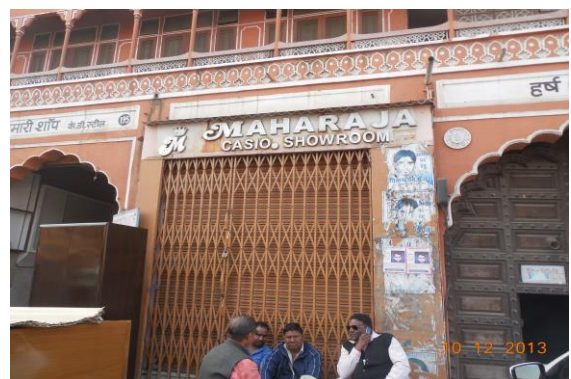
Photo 6
Locked, Ground Floor

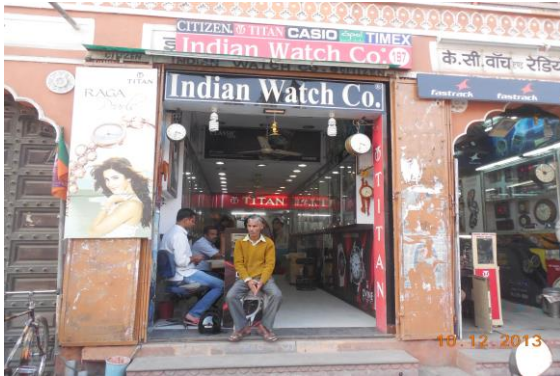
Photo 7
View of Shop No. 197, Ground Floor

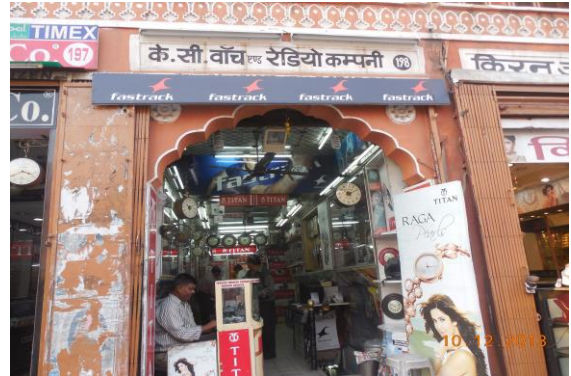
Photo 8
View of Shop No. 198, Ground Floor

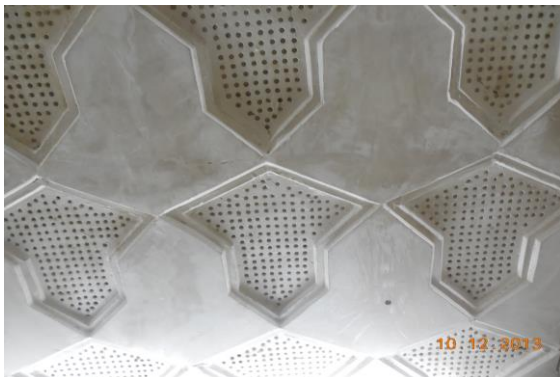
Photo 9
Covered With Falls Ceiling, Basement

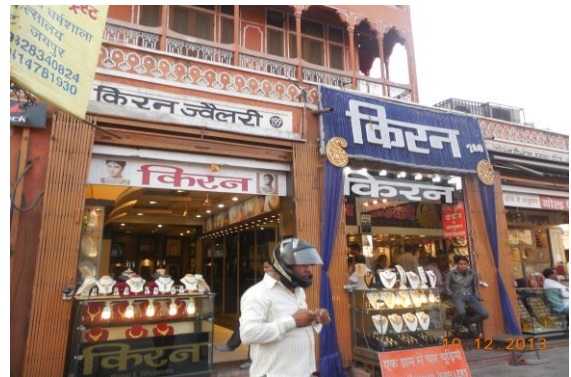
Photo 10
View of Shop No. 199/200/201/287/288, Ground Floor

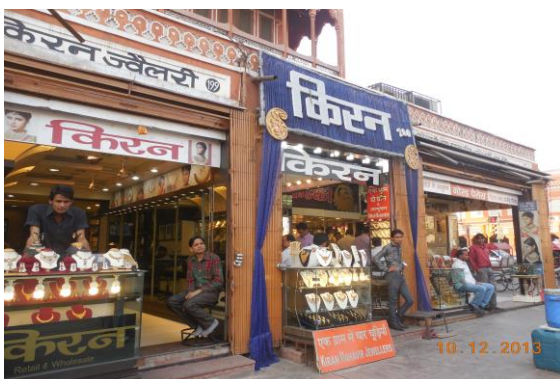
Photo 11
View of Shop No. 199/200/201/287/288, Ground Floor

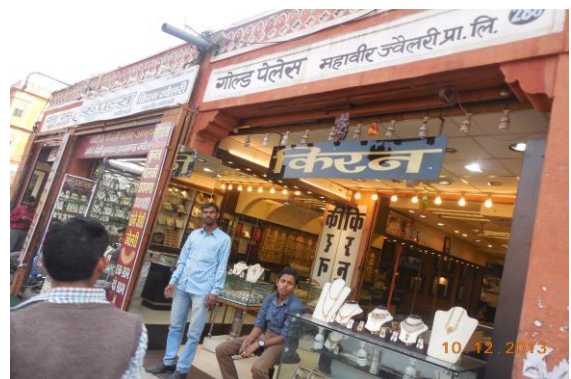
Photo 12
View of Shop No. 199/200/201/287/288, Ground Floor

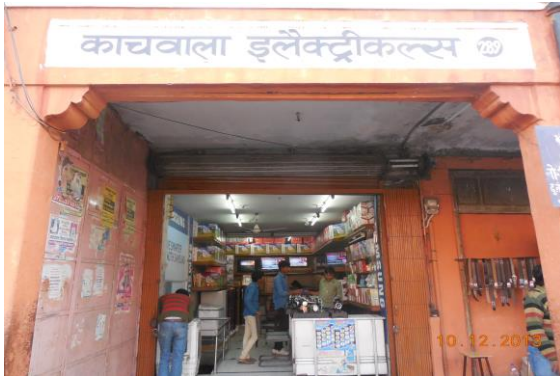
Photo 13
View of Shop No. 289, Ground Floor

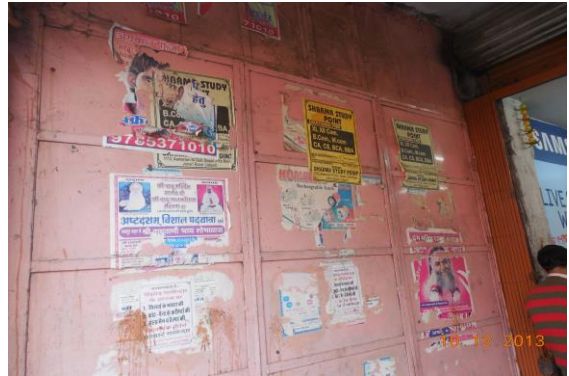
Photo 14
View of Varanda, Shop No. 289, Ground Floor

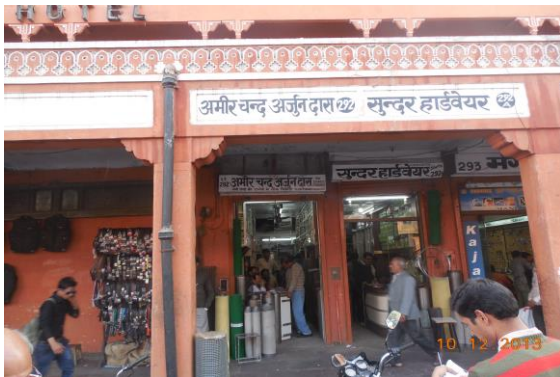
Photo 15
View of Shop No. 292, Ground Floor

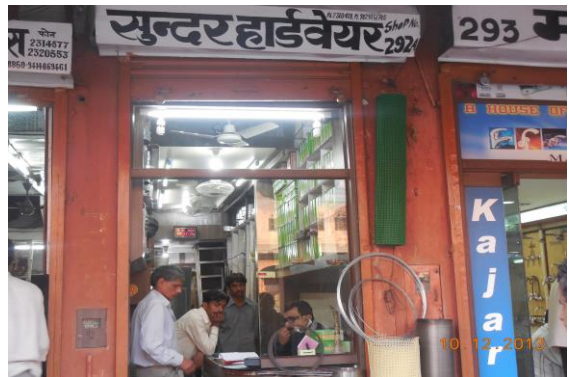
Photo 16
View of Shop No. 292A, Ground Floor

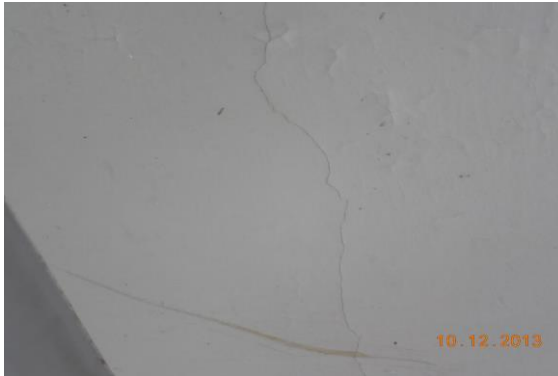
Photo 19

Inclined Crack on Roof of Shop No. 289, Ground Floor
Approx. Width = 0.15mm, Approx. Length = 3m.
Distance from Wall No.1 = 0m, Height from Floor = 3m.

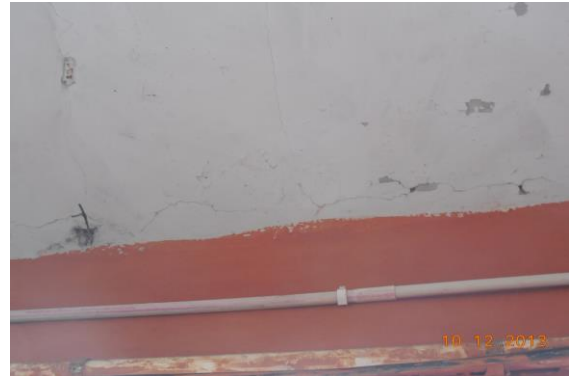
Photo 20

Inclined Crack on Roof of Varanda, Shop No. 292, Ground Floor
Approx. Width = 0.5mm, Approx. Length = 2.5m.
Distance from Left side Column = 0m, Height from Floor = 3m.

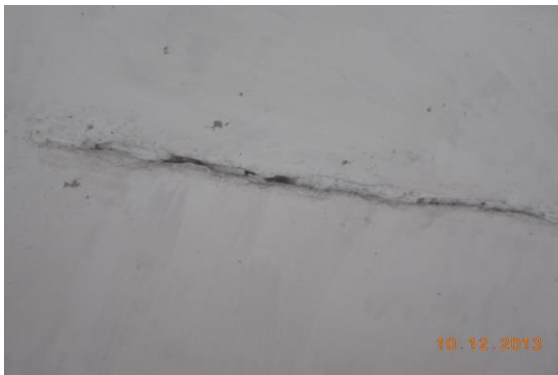
Photo 21

Horizontal Crack on Roof of Varanda, Shop No. 292, Ground Floor, Approx. Width = 20mm, Approx. Length = 2.5m. Distance from Right side External Column = 1m, Height from Floor = 3m.

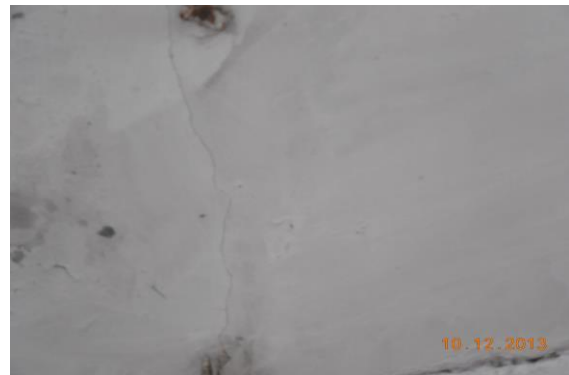
Photo 22

Horizontal Crack on Roof of Varanda, Shop No. 292, Ground Floor, Approx. Width = 0.4mm, Approx. Length = 2.5m. Distance from Right side External Column = 1.7m, Height from Floor = 3m.

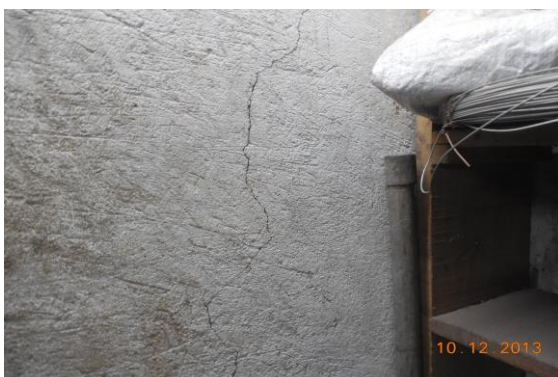
Photo 23

Inclined Crack on Wall No. 1 of Shop No. 292, Basement, Approx. Width = 0.8mm, Approx. Length = 2m. Distance from Wall No.4 = 0.5m, Height from Floor = 0m.

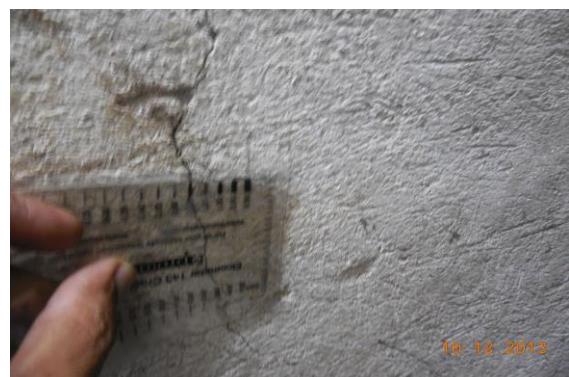
Photo 23A

Inclined Crack on Wall No. 1 of Shop No. 292, Basement, Approx. Width = 0.8mm, Approx. Length = 2m. Distance from Wall No.4 = 0.5m, Height from Floor = 0m.

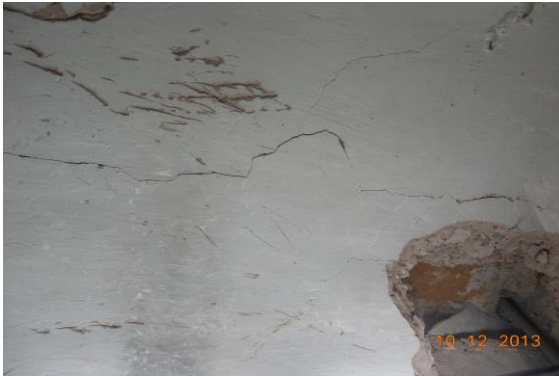
Photo 24

Inclined Crack on Roof of Shop No. 292, Basement, Approx. Width = 0.8mm, Approx. Length = 1.5m. Distance from Wall no.4 = 0m, Height from Floor = 2.5m.

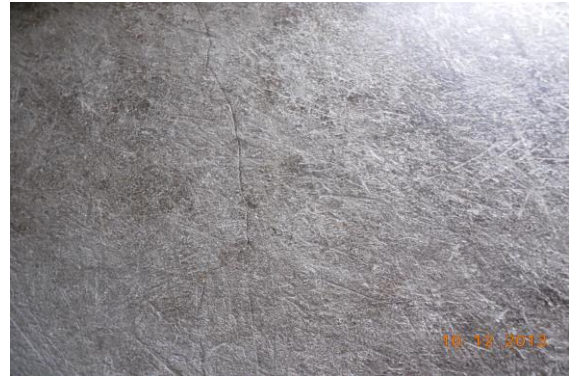
Photo 25

Inclined Crack on Wall No. 1 of Shop No. 292, Basement, Approx. Width = 0.8mm, Approx. Length = 1m. Distance from Wall no.4 = 1.6m, Height from Floor = 0.9m.

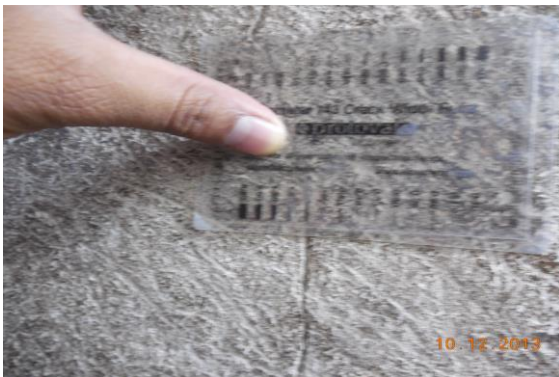
Photo 25A

Inclined Crack on Wall No. 1 of Shop No. 292, Basement, Approx. Width = 0.8mm, Approx. Length = 1m. Distance from Wall no.4 = 1.6m, Height from Floor = 0.9m.

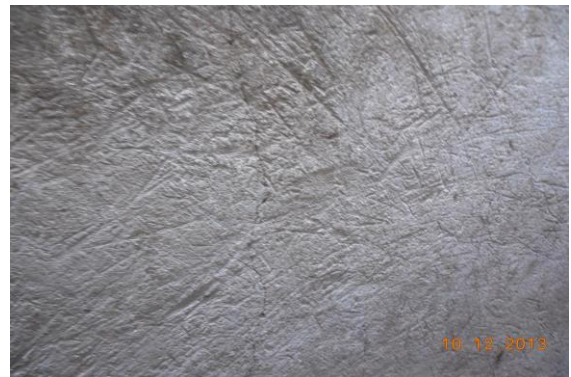
Photo 26

Inclined Crack on Wall No. 1 of Shop No. 292, Basement, Approx. Width = 0.5mm, Approx. Length = 1m. Distance from Wall No.4 = 1m, Height from Floor = 0.5m.

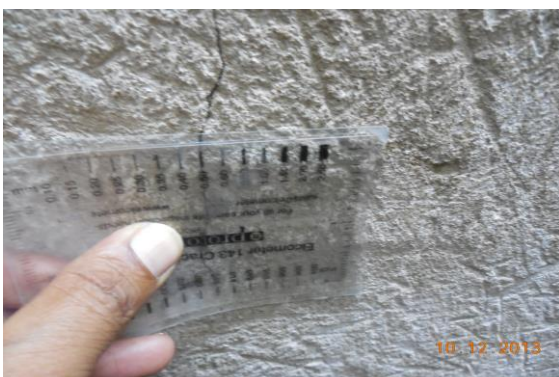
Photo 26A

Inclined Crack on Wall No. 1 of Shop No. 292, Basement, Approx. Width = 0.5mm, Approx. Length = 1m. Distance from Wall No.4 = 1m, Height from Floor = 0.5m.

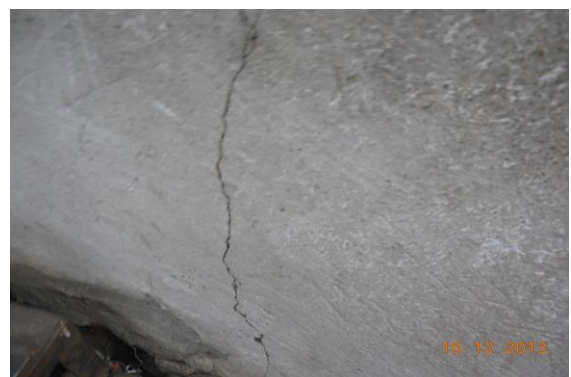
Photo 27

Inclined Crack on Wall No. 1 of Shop No. 292, Basement, Approx. Width = 0.8mm, Approx. Length = 1m. Distance from Wall No.4 = 2m, Height from Floor = 1m.

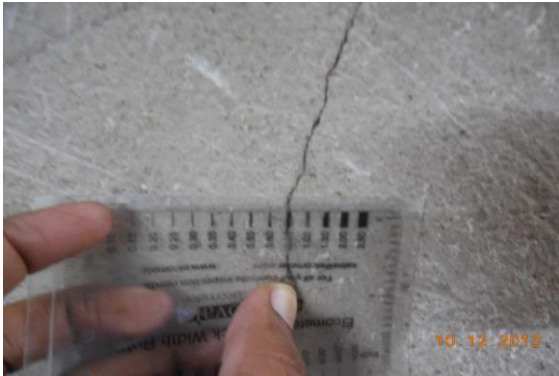
Photo 27A

Inclined Crack on Wall No. 1 of Shop No. 292, Basement, Approx. Width = 0.8mm, Approx. Length = 1m. Distance from Wall No.4 = 2m, Height from Floor = 1m.

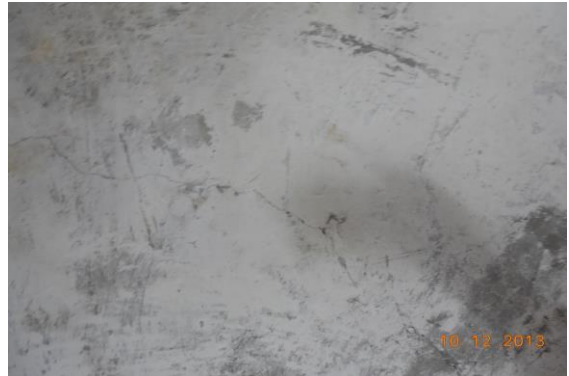
Photo 28

Inclined Crack on Wall No. 2 of staircase, Shop No. 292A, Basement, Approx. Width = 0.8mm, Approx. Length = 0.9m. Distance from Wall no.4 = 0.05m, Height from Floor = 0m.

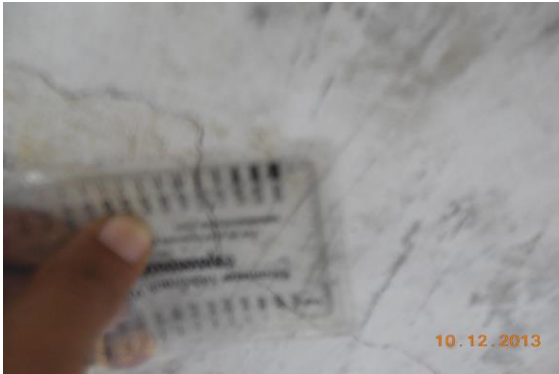
Photo 28A

Inclined Crack on Wall No. 2 of staircase, Shop No. 292A, Basement, Approx. Width = 0.8mm, Approx. Length = 0.9m. Distance from Wall no.4 = 0.05m, Height from Floor = 0m.

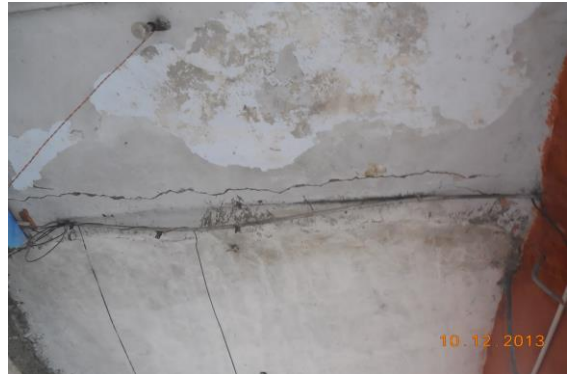
Photo 29

Horizontal Crack on Roof of Varanda , Shop No. 293, Ground Floor, Approx. Width = 3.5mm, Approx. Length = 3m. Distance from External Column = 0m, Height from Floor = 3m.
