Pre Building Condition Survey Report

Name and Address of Structure :	Choti Chopar to Badi Chopar (Down Line)
---------------------------------	---

Name of the Project	Contract JMRC-UG1B “Design and Construction of Tunnel between Chandpole and Badi Chouper and reverse line by Shield TBM, Underground Metro Stations at Choti Chouper and Badi Chouper by Cut and Cover Methods on East West Corridor of Jaipur Metro Rail Corporation Limited .”	
Owner :

Pre Building Condition Survey Report Choti Chopar to Badi Chopar (Down Line)

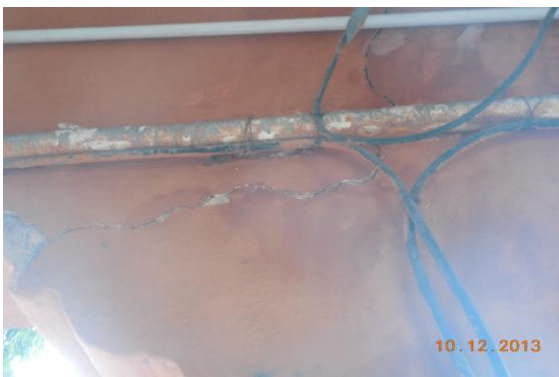
Photo 30

Inclined Crack on Beam Right side External of Varanda , Shop No. 293, Ground Floor, Approx. Width = 3mm, Approx. Length = 1.3m. Distance External Column = 0m, Height Floor = 2.5m.

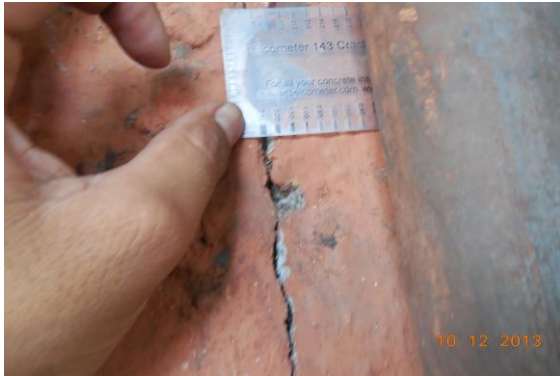
Photo 31A

Vertical Crack on Wall No. 4 of Varanda , Shop No. 293, Ground Floor, Approx. Width = 2mm, Approx. Length = 2m.

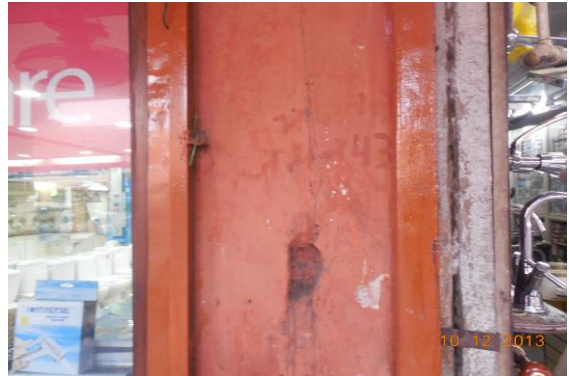
Photo 32

Vertical Crack on Wall No. 4 of Varanda , Shop No. 293, Ground Floor, Approx. Width = 2.5mm, Approx. Length = 3m. Height from Floor = 0m.

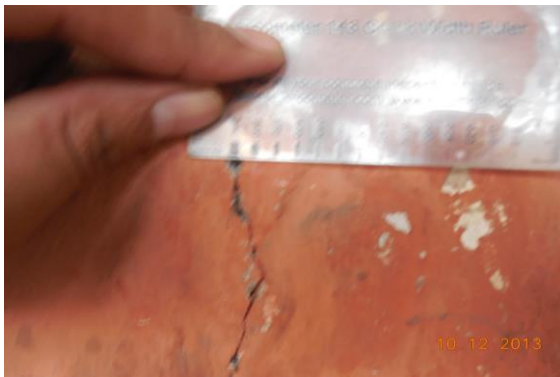
Photo 32A

Vertical Crack on Wall No. 4 of Varanda , Shop No. 293, Ground Floor, Approx. Width = 2.5mm, Approx. Length = 3m. Height from Floor = 0m.

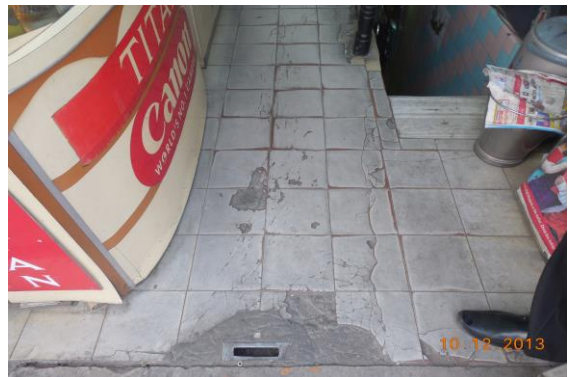
Photo 33

Damaged Portion on Wall No. Floor of Shop No. 198 of Ground Floor

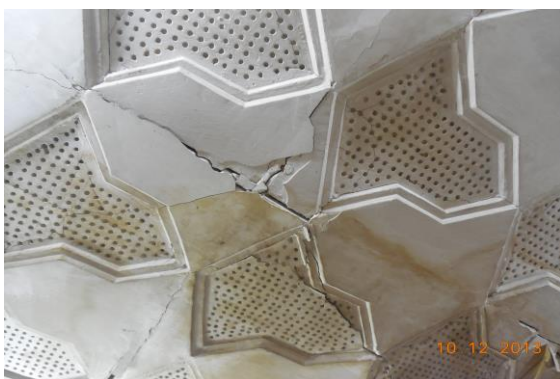
Photo 34

Damaged Portion on Roof of Shop No. 198 of Basement

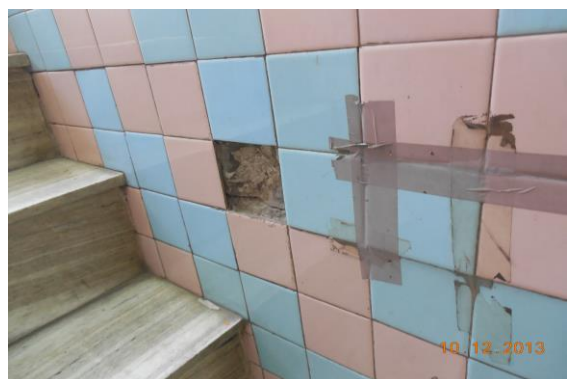
Photo 35

Peeling of Plaster on Floor of Shop No. 198 of Ground Floor

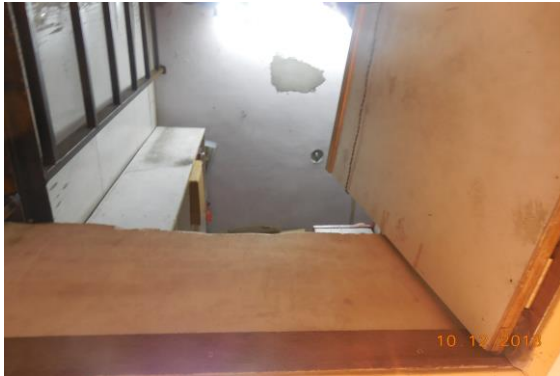
Photo 36

Peeling of Plaster on Roof of Shop No. 199 of Ground Floor

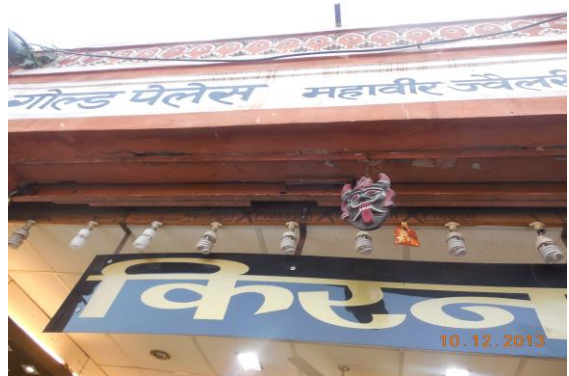
Photo 37

Peeling of Plaster on Roof of Varanda of Shop No. 288, Ground Floor

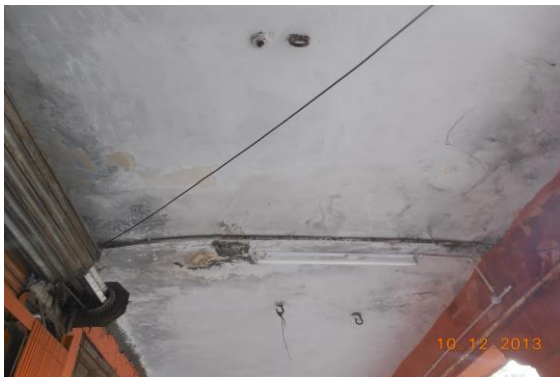
Photo 38

Dampness/Seepage on Roof of Varanda of Shop No. 289, Ground Floor

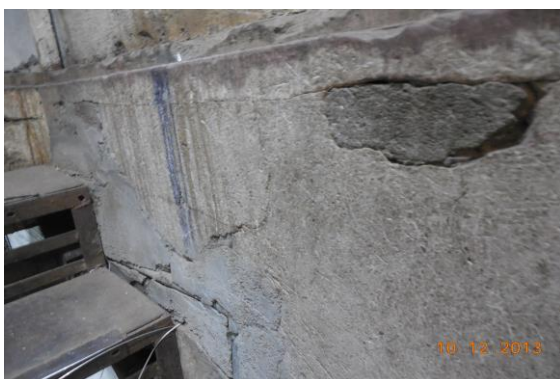
Photo 40

Peeling of Plaster on Wall No. 2 of staircase of Shop No. 292, Upper Ground Floor

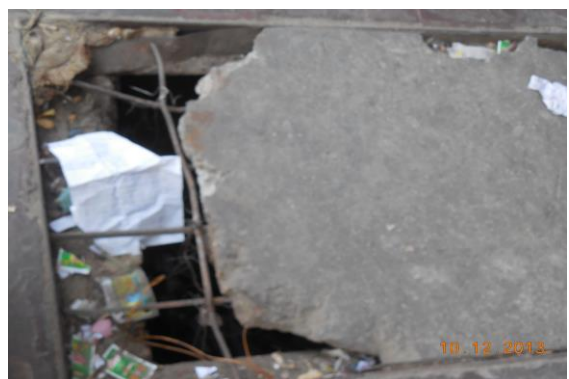
Photo 41

Damaged Portion on Floor of Varanda of Shop No. 292, Ground Floor

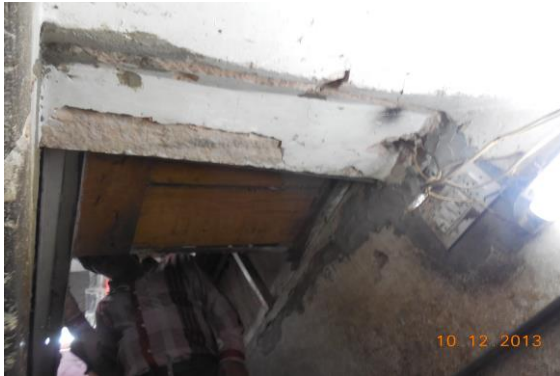
Photo 42

Damaged Portion on Roof of staircase of Shop No. 292, Basement

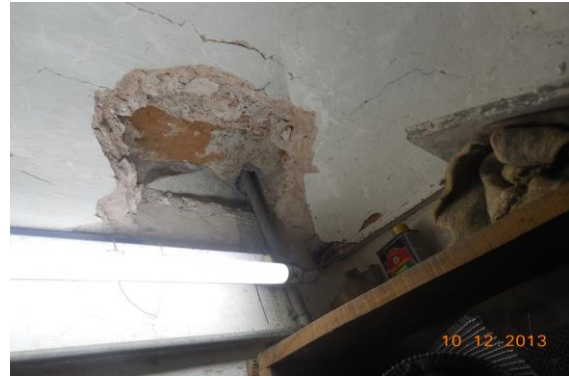
Photo 43

Damaged Portion on Roof of Shop No. 292 of Basement

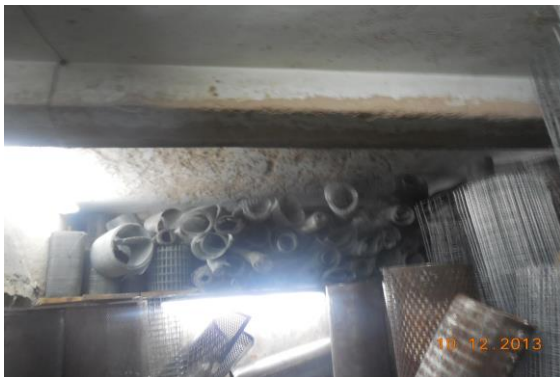
Photo 44

Peeling of Plaster on Roof of Shop No. 292 of Basement

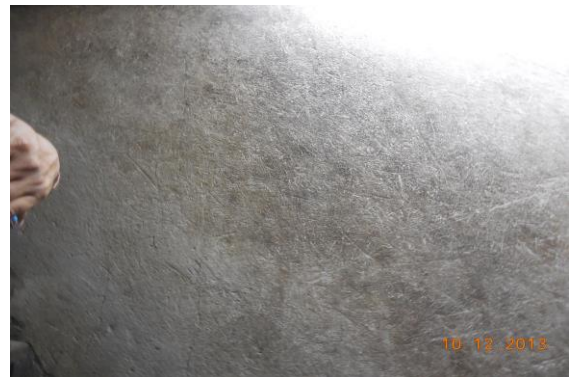
Photo 45

Peeling of Plaster on Wall No. 1 of Shop No. 292 of Basement

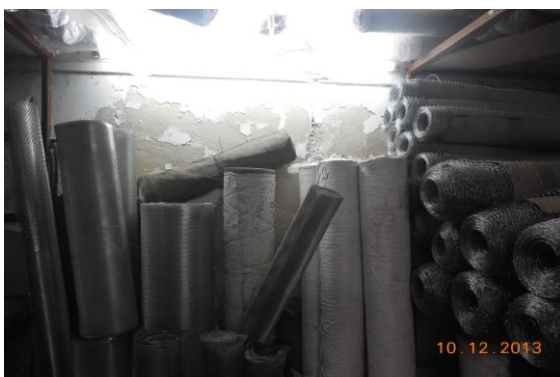
Photo 46

Peeling of Plaster on Wall No. 1 of Shop No. 292A of Basement

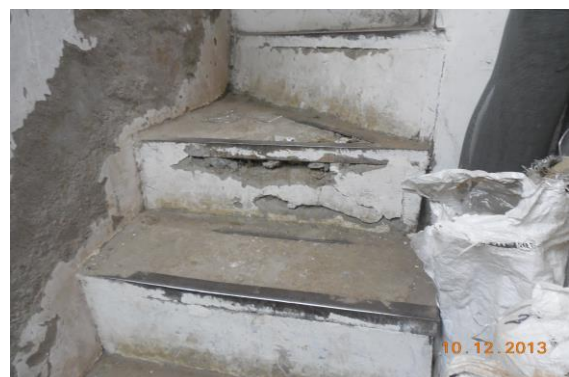
Photo 47

Damaged Portion on Step of Staircase of Shop No. 292A, Basement

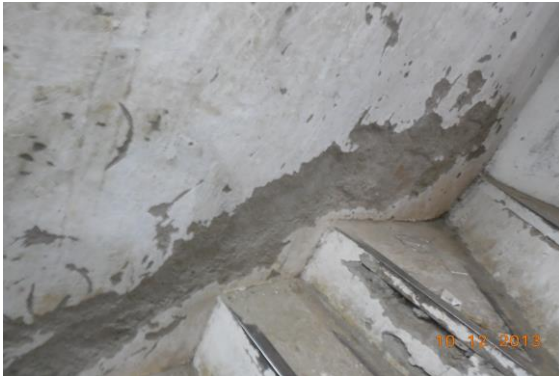
Photo 48

Peeling of Plaster on Wall No. 4 of staircase of Shop No. 292A, Basement

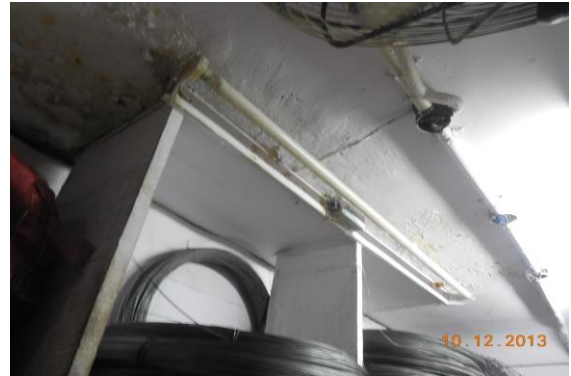
Photo 49

Dampness/Seepage on Roof of Shop No. 292A of Upper Ground Floor

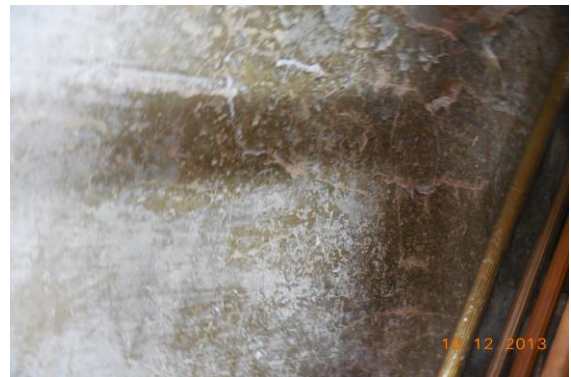
Photo 50

Peeling of Plaster on Floor & Entry Gate No.1 of Shop No. 293 of Ground Floor

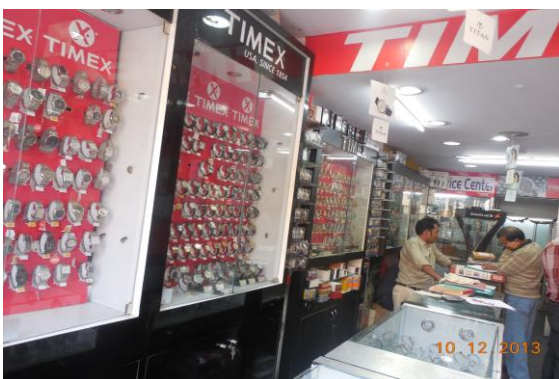
Photo 51

Peeling of Plaster on Wall No. 1 of Shop No. 293 of Ground Floor

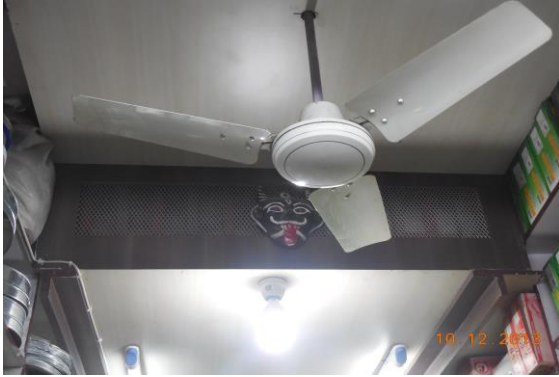
Photo 90

Roof of Shop No. 292A of Ground Floor Covered With False Ceiling

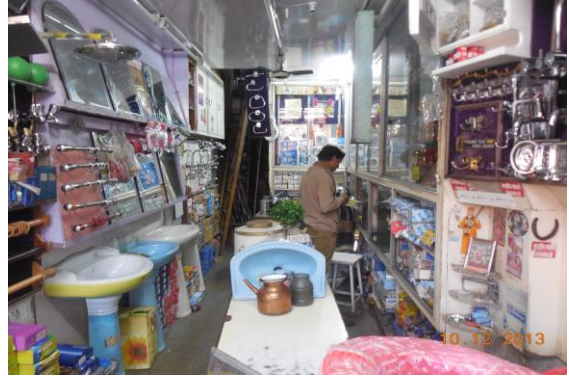
Photo 91

All Walls of Shop No. 293 of Ground Floor Covered with Material

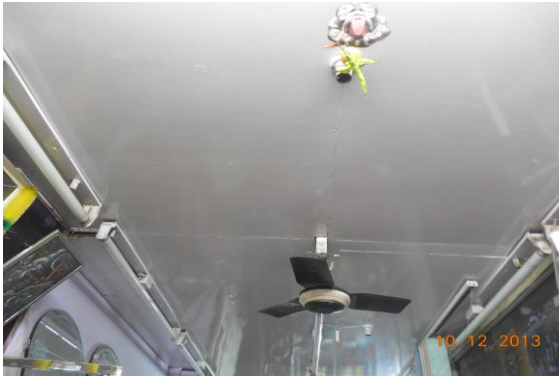
Photo 92

Roof of Shop No. 293 of Ground Floor Covered with False Ceiling

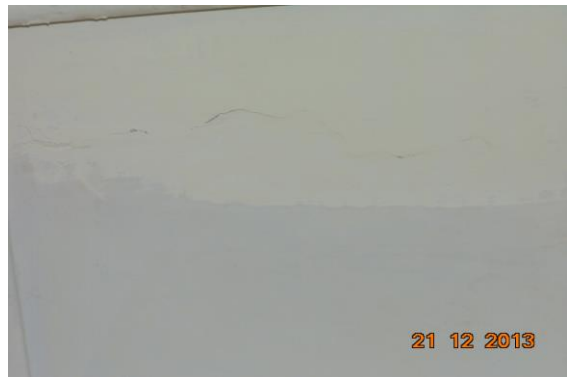
Photo 28
Inclined Crack on Roof of Varanda No.2, Library, Ground floor Approx. Width = 0.5mm, Approx. Length = 1m. Distance from = m, Height from Floor = m.

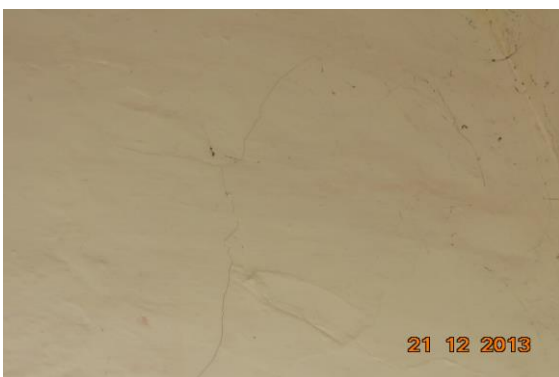
Photo 29
Inclined Crack on Wall No. 4 of Room No. 1, Library, Ground floor Approx. Width = 0.3mm, Approx. Length = 3m. Distance from = m, Height from Floor = m.

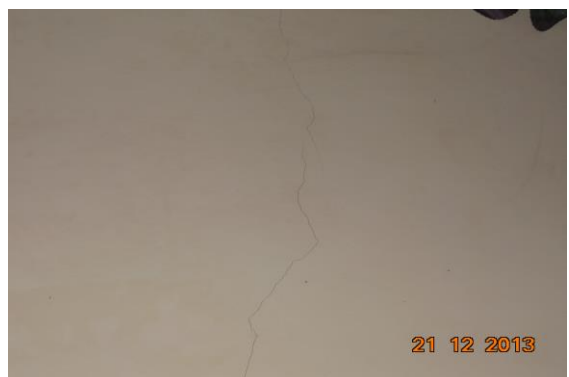
Photo 30
Inclined Crack on Wall No. 1 of, Library, Ground floor Approx. Width = 0.3mm, Approx. Length = 3m. Distance from = m, Height from Floor = m.

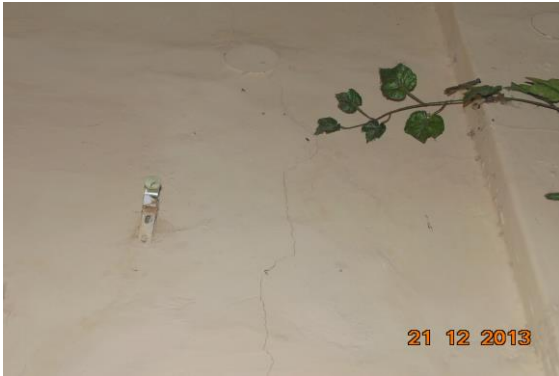
Photo 31

Inclined Crack on Wall No. 3 of Varanda No.5, Library, Ground floor
Approx. Width = 0.3mm, Approx. Length = 3m. Distance from = m,
Height from Floor = m.

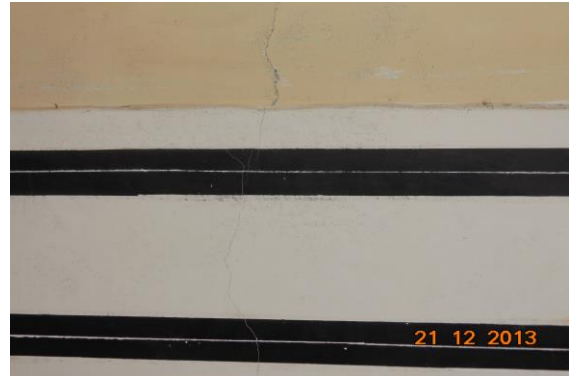
Photo 32

Inclined Crack on Wall No. 4 of Varanda No.5, Library, Ground floor
Approx. Width = 1mm, Approx. Length = 3m. Distance from = m, Height
from Floor = m.

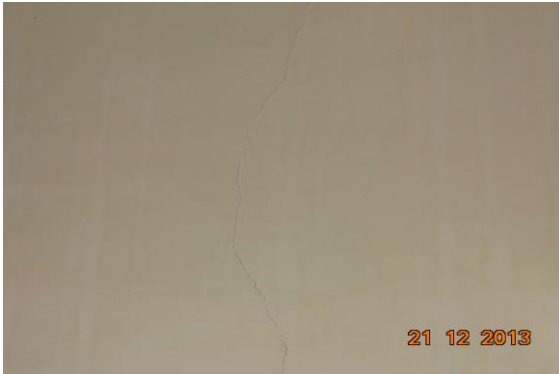
Photo 33

Inclined Crack on Wall No. 4 of Varanda No.5, Library, Ground floor
Approx. Width = 0.15mm, Approx. Length = 2m. Distance from Wall
No.1 = 3m, Height from Floor = 1m.

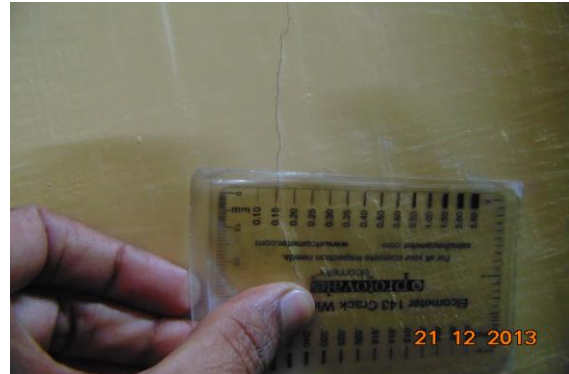
Photo 33A

Inclined Crack on Wall No. 4 of Varanda No.5, Library, Ground floor
Approx. Width = 0.15mm, Approx. Length = 2m. Distance from Wall
No.1 = 3m, Height from Floor = 1m.

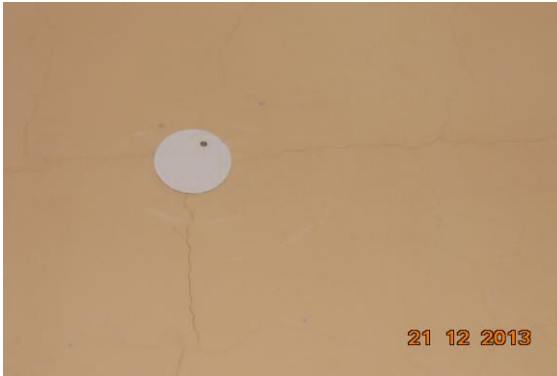
Photo 35

Inclined Crack on Wall No. 4 of Room No. 8, Library, Ground floor
Approx. Width = 0.3mm, Approx. Length = 2m. Distance from = m,
Height from Floor = m.

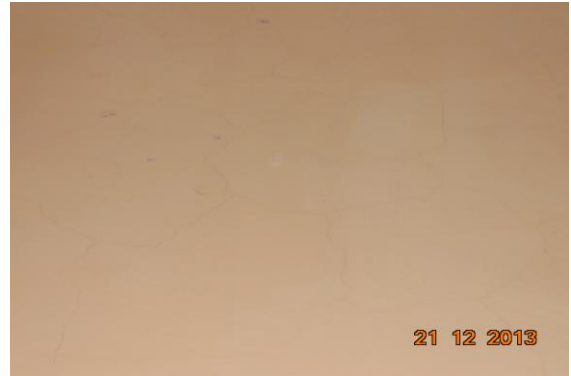
Photo 36

Inclined Crack on Wall No. 1 of Room No. 8, Library, Ground floor
Approx. Width = 0.3mm, Approx. Length = 2m. Distance from = m,
Height from Floor = m.

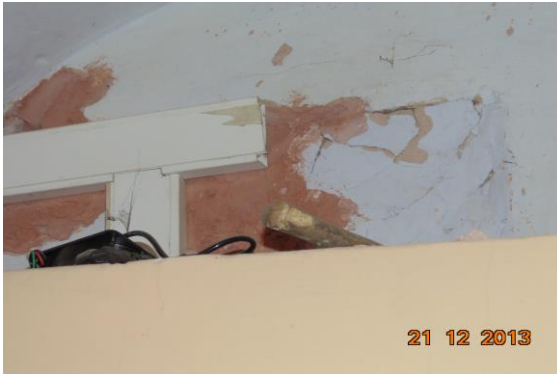
Photo 37

Inclined Crack on Wall No. 1 of Room No. 8, Library, Ground floor
Approx. Width = 2.5mm, Approx. Length = 0.5m. Distance from = m,
Height from Floor = m.

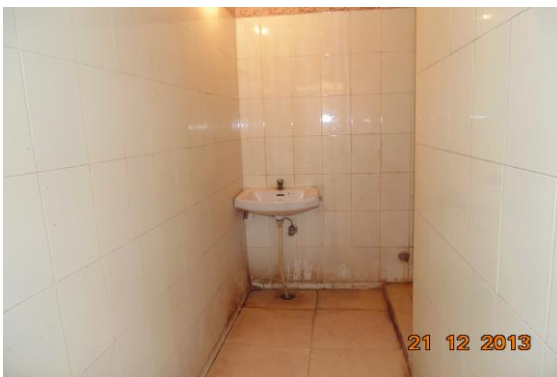
Photo 38A

Inclined Crack on Wall No. 3 of Room No. 8, Library, Ground floor
Approx. Width = 0.5mm, Approx. Length = 3m. Distance from = m,
Height from Floor = m.

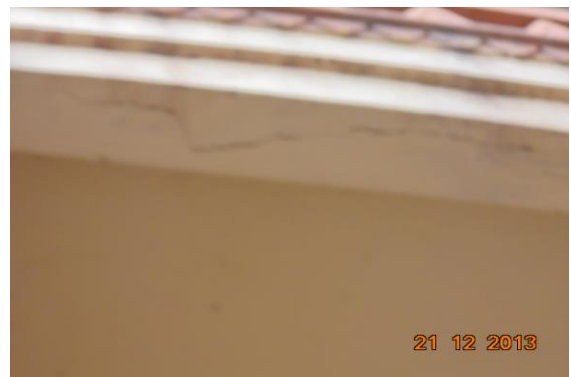
Photo 39

Inclined Crack on Wall No. 2 of Open sky area, Library, Ground floor
Approx. Width = 2.5mm, Approx. Length = 0.5m. Distance from = m,
Height from Floor = m.

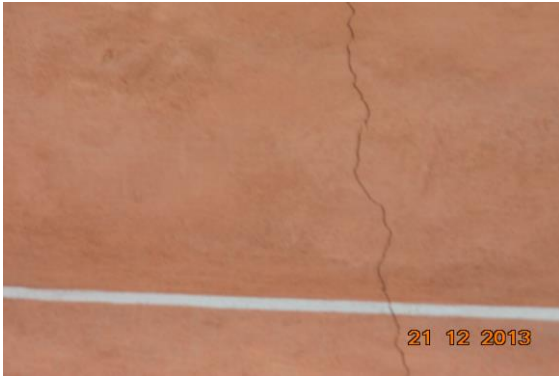
Photo 40

Inclined Crack on of , Ground floor
Approx. Width = 2mm, Approx. Length = 8m.
Distance from Wall no.1 = 6m, Height from Floor = 3m.

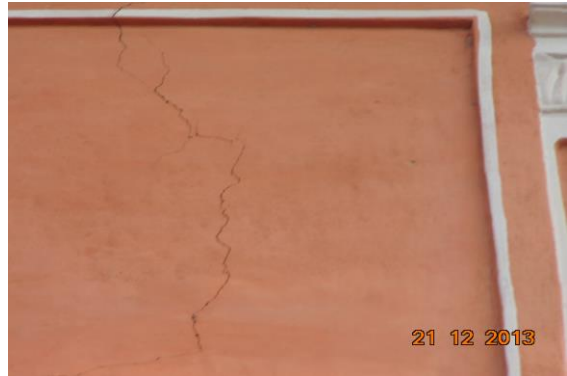
Photo 40A

Inclined Crack on of , Ground floor
Approx. Width = 2mm, Approx. Length = 8m.
Distance from Wall no.1 = 6m, Height from Floor = 3m.

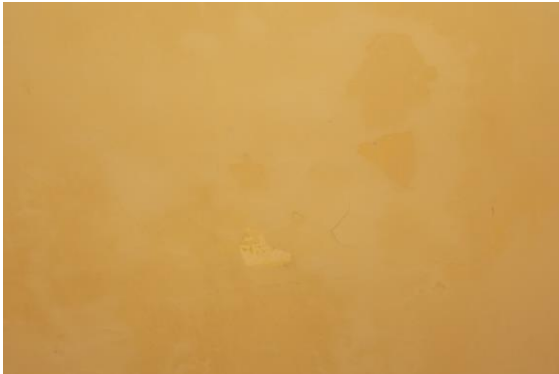
Photo 41

Inclined Crack on Roof of Gallery, Library, First Floor
Approx. Width = 0.3mm, Approx. Length = 0.5m.
Distance from = m, Height from Floor = m.

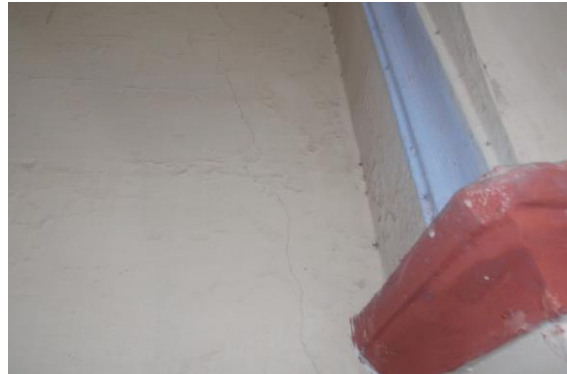
Photo 42

Inclined Crack on Wall No. 3 of Hall No. 1, Library, First Floor
Approx. Width = 0.3mm, Approx. Length = 1m.
Distance from = m, Height from Floor = m.

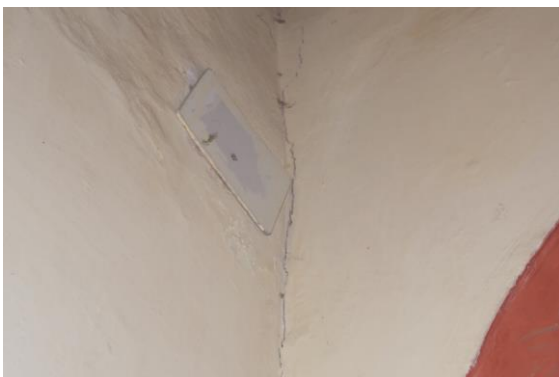
Photo 43

Vertical Crack on Wall No. 2 & 3 of Hall No. 1, Library, First Floor
Approx. Width = 1mm, Approx. Length = 1.5m. Distance from = Corner
of Wall No.2 & 3m, Height from Floor = 2m.

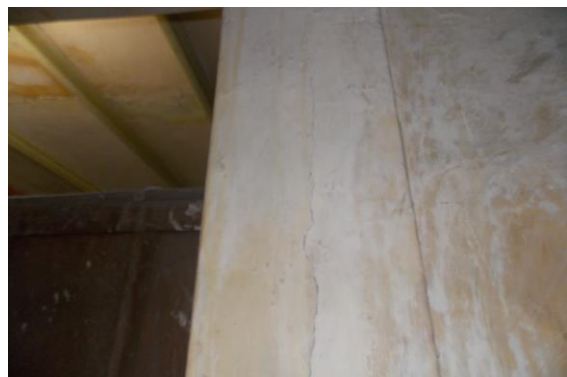
Photo 44

Inclined Crack on Wall No. 3 of Passage No.2, Library, First Floor
Approx. Width = 0.5mm, Approx. Length = 1.2m. Distance from Wall
no.1 = 4m, Height from Floor = 1.6m.

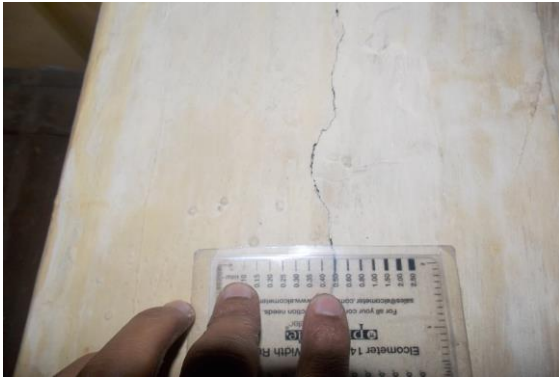
Photo 44A

Inclined Crack on Wall No. 3 of Passage No.2, Library, First Floor
Approx. Width = 0.5mm, Approx. Length = 1.2m.
Distance from Wall no.1 = 4m, Height from Floor = 1.6m.

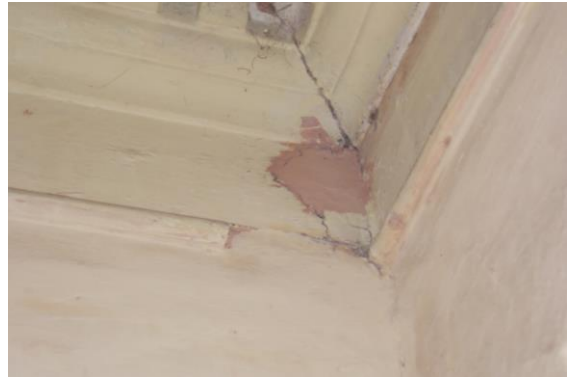
Photo 45

Inclined Crack on Wall No. 2 of Passage No.2, Library, First Floor
Approx. Width = 5mm, Approx. Length = 2m.
Distance from = m, Height from Floor = m.

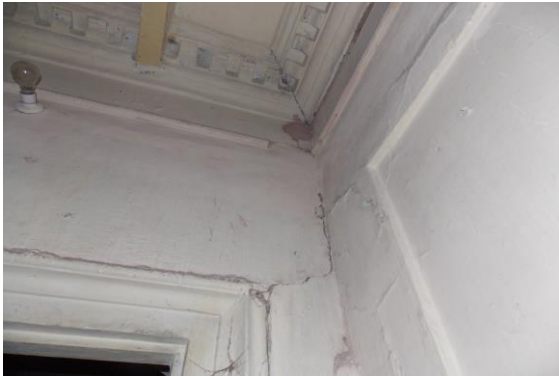
Photo 46

Inclined Crack on Wall No. 2 & Roof of Passage No.2, Library, First Floor
Approx. Width = 5mm, Approx. Length = 2m. Distance from Wall no.3 = 0.25m, Height from Floor = 1.3m.

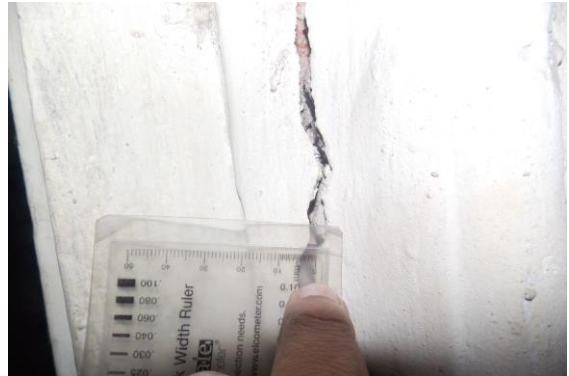
Photo 46A

Inclined Crack on Wall No. 2 & Roof of Passage No.2, Library, First Floor
Approx. Width = 5mm, Approx. Length = 2m. Distance from Wall no.3 = 0.25m, Height from Floor = 1.3m.

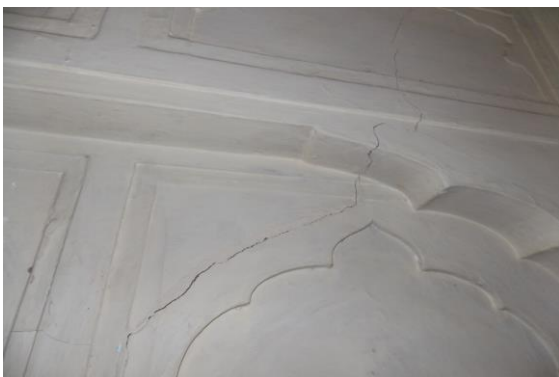
Photo 47

Inclined Crack on Wall No. 4 of Hall No. 4, Library, First Floor
Approx. Width = 1.5mm, Approx. Length = 1.5m.
Distance from Wall no.1 = 1.5m, Height from Floor = 1.2m.

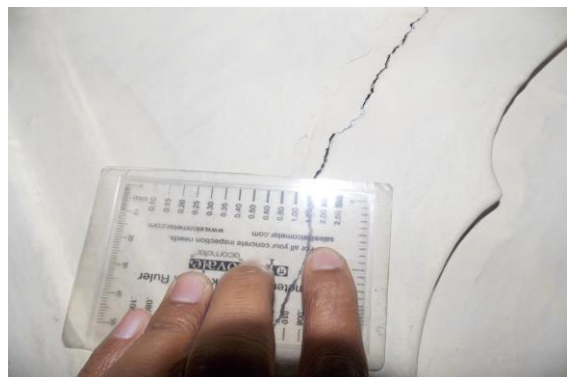
Photo 47A

Inclined Crack on Wall No. 4 of Hall No. 4, Library, First Floor
Approx. Width = 1.5mm, Approx. Length = 1.5m.
Distance from Wall no.1 = 1.5m, Height from Floor = 1.2m.

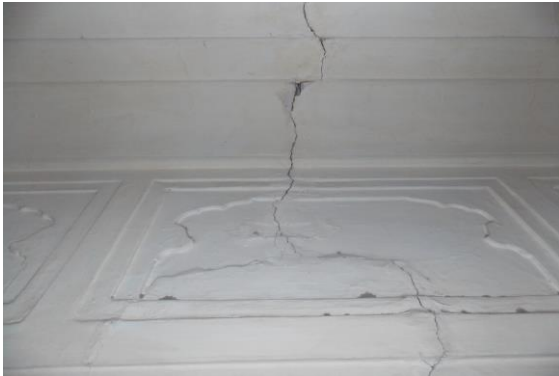
Photo 48

Inclined Crack on Wall No. 4 & Roof of Hall No. 4, Library, First Floor
Approx. Width = 0.8mm, Approx. Length = 4.2m. Distance from Wall no.1 = 7.5m, Height from Floor = 0.05m.

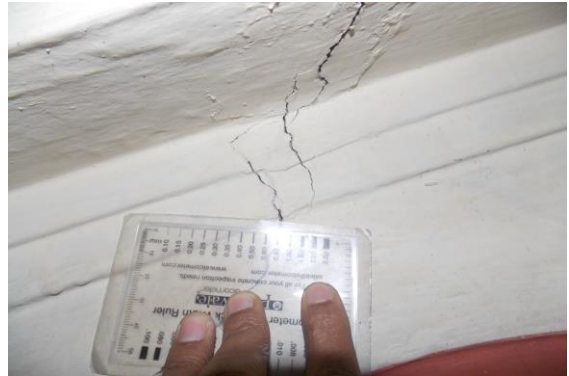
Photo 48A

Inclined Crack on Wall No. 4 & Roof of Hall No. 4, Library, First Floor
Approx. Width = 0.8mm, Approx. Length = 4.2m. Distance from Wall no.1 = 7.5m, Height from Floor = 0.05m.

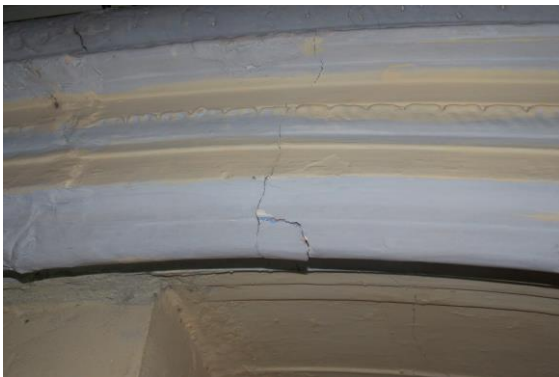
Photo 49

Inclined Crack on Wall No. 4 & Roof of Hall No. 4, Library, First Floor
Approx. Width = 0.8mm, Approx. Length = 1.5m.
Distance from Wall No.1 = 7.7m, Height from Floor = 2.2m.

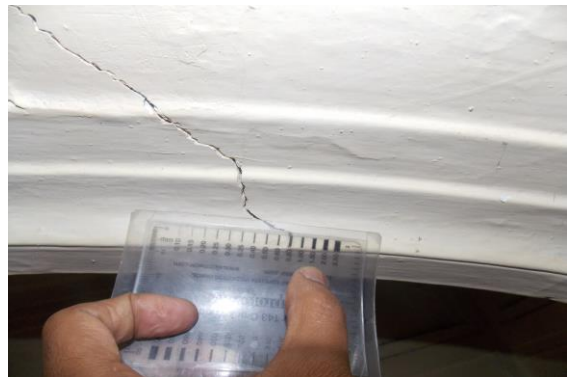
Photo 49A

Inclined Crack on Wall No. 4 & Roof of Hall No. 4, Library, First Floor
Approx. Width = 0.8mm, Approx. Length = 1.5m. Distance from Wall No.1 = 7.7m, Height from Floor = 2.2m.

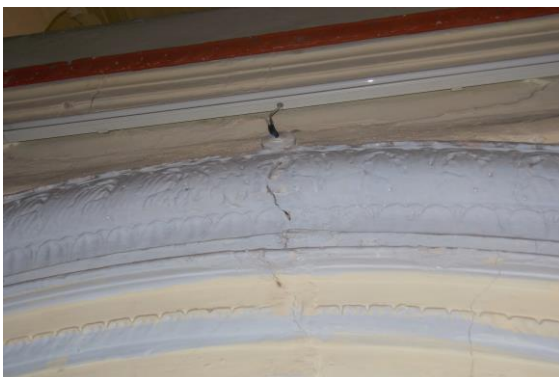
Photo 50

Inclined Crack on Wall No. 4 of Hall No. 4, Library, First Floor Approx.
Width = 2mm, Approx. Length = 0.5m. Distance from = m, Height from Floor = m.

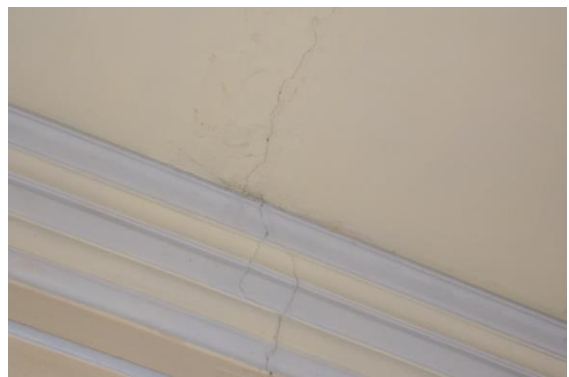
Photo 51

Inclined Crack on Roof of Hall No. 5, Library, First Floor Approx. Width
= 0.35mm, Approx. Length = 4m. Distance from Wall No.2 = 6.8m, Height from Floor = 4.2m.

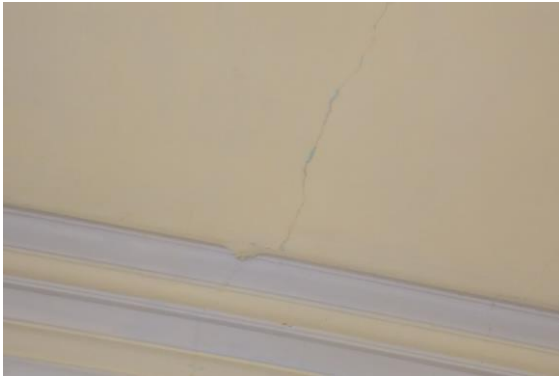
Photo 52

Inclined Crack on Roof of Hall No. 5, Library, First Floor Approx. Width = 0.3mm, Approx. Length = 1m.
Distance from = m, Height from Floor = m.

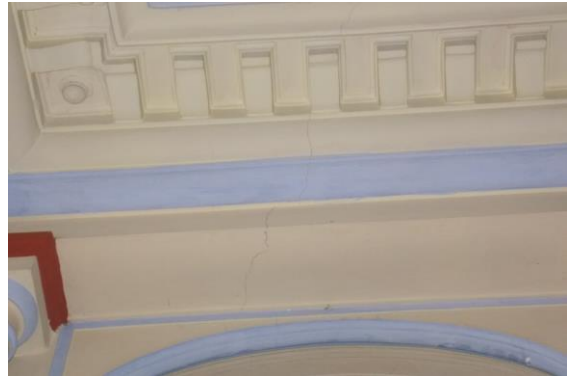
Photo 53

Inclined Crack on Wall No. 4 & Roof of Hall No. 5, Library, First Floor Approx. Width = 1mm, Approx. Length = 1.3m. Distance from Wall No.1 = 0.6m, Height from Floor = 5m.

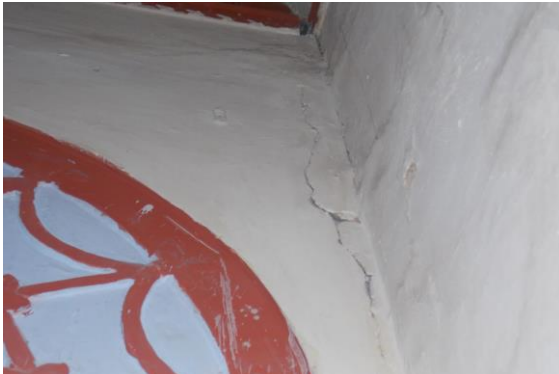
Photo 54

Inclined Crack on Wall No. 2 of Hall No. 6, Library, First Floor Approx. Width = 2mm, Approx. Length = 2m. Distance from = m, Height from Floor = m.

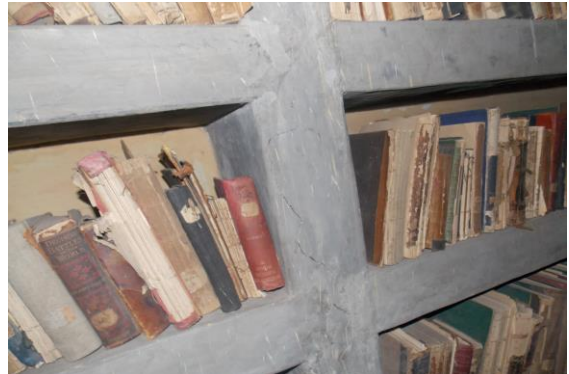
Photo 55

Inclined Crack on Wall No. 1 of Hall No. 6, Library, First Floor Approx. Width = 1.5mm, Approx. Length = 1.5m. Distance from Wall no.3 = 1.2m, Height from Floor = 0.3m.

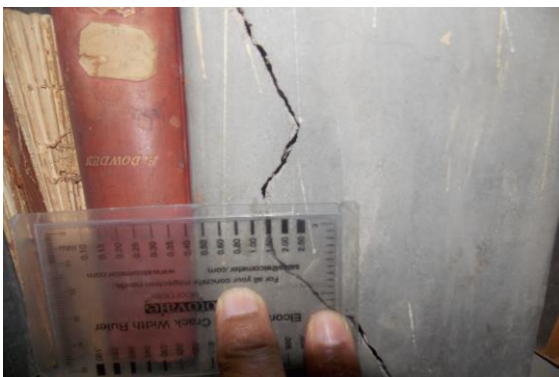
Photo 55A

Inclined Crack on Wall No. 1 of Hall No. 6, Library, First Floor Approx. Width = 1.5mm, Approx. Length = 1.5m. Distance from Wall no.3 = 1.2m, Height from Floor = 0.3m.

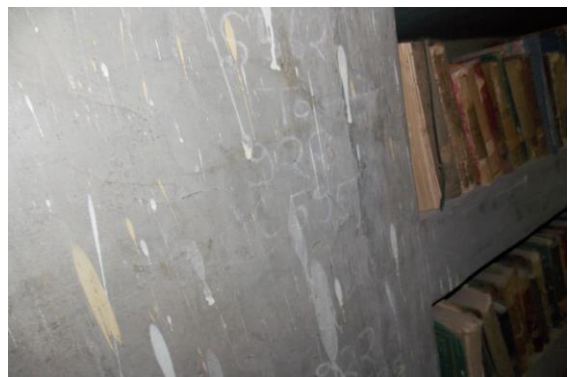
Photo 56

Inclined Crack on Wall No. 1 of Hall No. 6, Library, First Floor Approx. Width = 0.6mm, Approx. Length = 2.5m. Distance from Wall No.4 = 3.7m, Height from Floor = 0m.

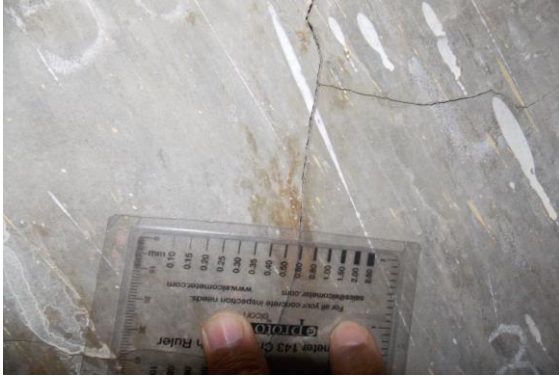
Photo 56A

Inclined Crack on Wall No. 1 of Hall No. 6, Library, First Floor
Approx. Width = 0.6mm, Approx. Length = 2.5m.
Distance from Wall No.4 = 3.7m, Height from Floor = 0m.

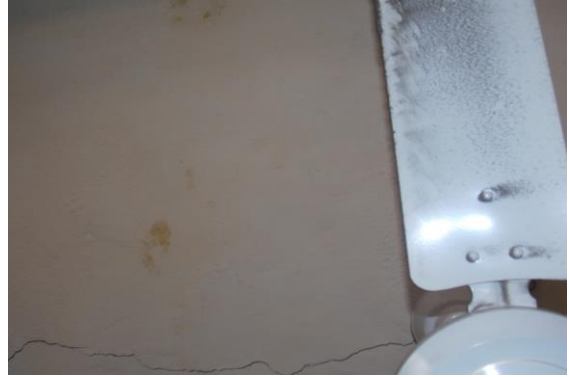
Photo 57

Inclined Crack on Roof of Hall No. 7, Library, First Floor
Approx. Width = 1mm, Approx. Length = 4.5m.
Distance from Wall no.1 = 1.6m, Height from Floor = 3m.

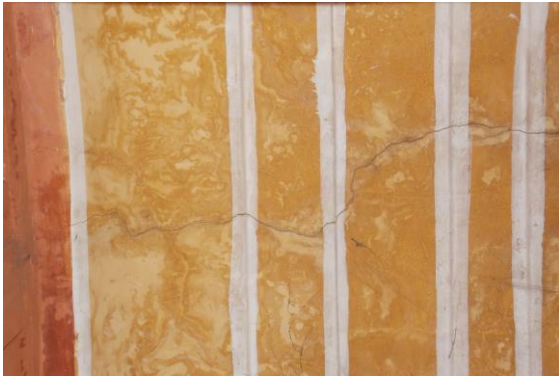
Photo 58

Inclined Crack on Roof of Balcony, Library, First Floor
Approx. Width = 0.4mm, Approx. Length = 1m.
Distance from Wall No.1 = 4.5m, Height from Floor = 3.2m.

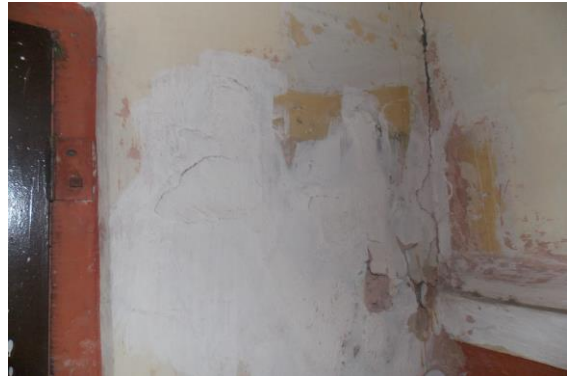
Photo 59

Inclined Crack on Wall No. 2 of Gallery No.1, Library, Second Floor
Approx. Width = 5mm, Approx. Length = 3m. Distance from = m, Height from Floor = m.

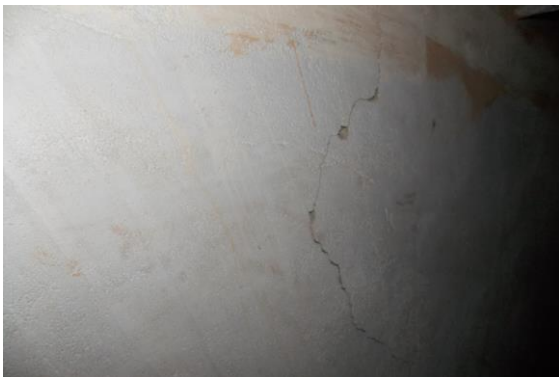
Photo 60

Inclined Crack on Wall No. 2 of Staircase FF to SF, Library, Second Floor
Approx. Width = 4mm, Approx. Length = 2m. Distance from Wall no.3 = 1.5m, Height from Floor = 0m.

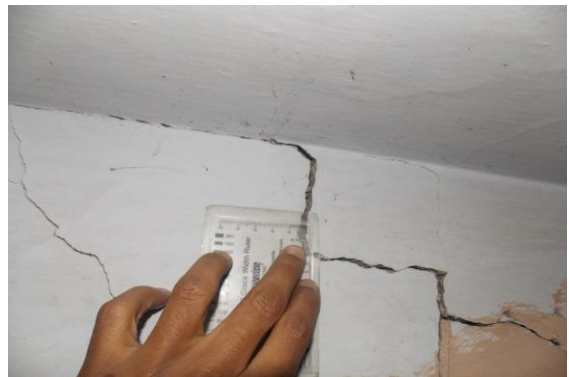
Photo 60A

Inclined Crack on Wall No. 2 of Staircase FF to SF, Library, Second Floor
Approx. Width = 4mm, Approx. Length = 2m. Distance from Wall no.3 = 1.5m, Height from Floor = 0m.

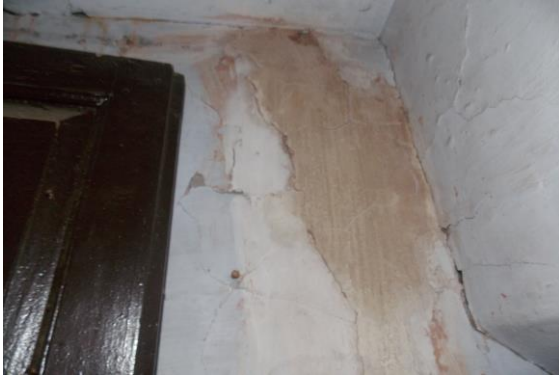
Photo 61

Inclined Crack on Wall No. 2 of Staircase FF to SF, Library, Second Floor Approx. Width = 4mm, Approx. Length = 3m. Distance from = m, Height from Floor = m.

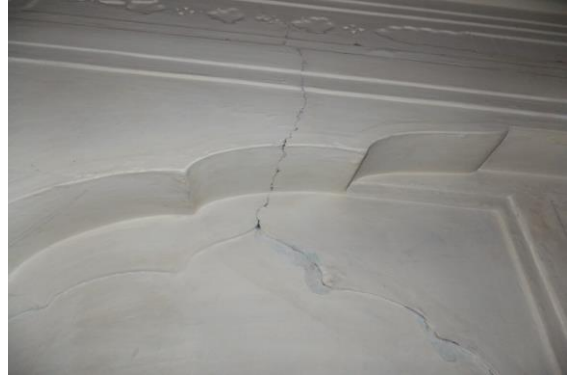
Photo 62

Inclined Crack on Wall No. 1 of Gallery No.3, Library, Second Floor Approx. Width = 0.5mm, Approx. Length = 1.5m. Distance from = m, Height from Floor = 1m.

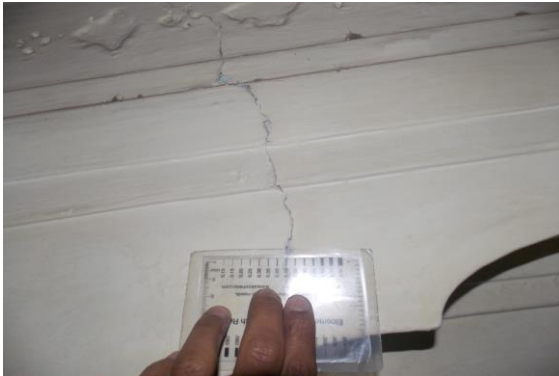
Photo 62A

Inclined Crack on Wall No. 1 of Gallery No.3, Library, Second Floor Approx. Width = 0.5mm, Approx. Length = 1.5m. Distance from = m, Height from Floor = 1m.

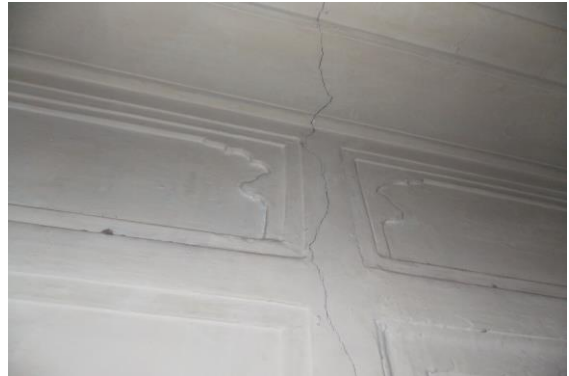
Photo 63

Inclined Crack on Wall No. 1 & Roof of Gallery No.6, Library, Second Floor Approx. Width = 0.4mm, Approx. Length = 2m. Distance from Wall no.4 = 3m, Height from Floor = 1.7m.

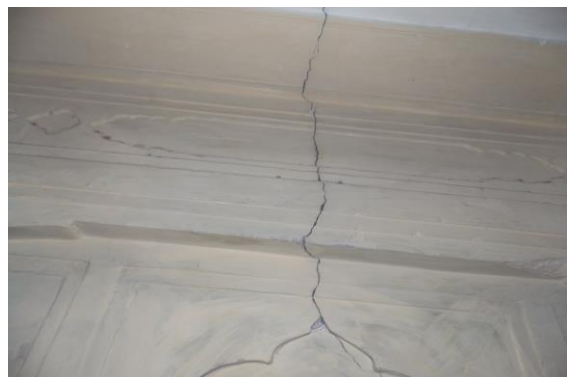
Photo 63A

Inclined Crack on Wall No. 1 & Roof of Gallery No.6, Library, Second Floor Approx. Width = 0.4mm, Approx. Length = 2m. Distance from Wall no.4 = 3m, Height from Floor = 1.7m.

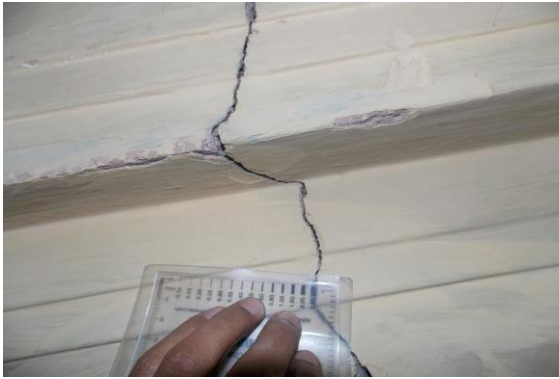
Photo 64

Inclined Crack on Wall No. 1 & Roof of Gallery No.7, Library, Second Floor Approx. Width = 2.5mm, Approx. Length = 3.5m. Distance from Wall no.3 = 2.5m, Height from Floor = 0.3m.

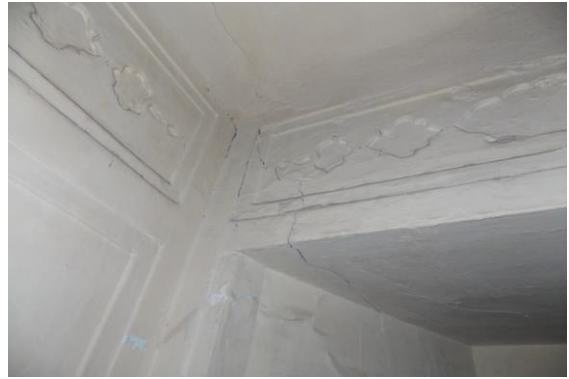
Photo 64A

Inclined Crack on Wall No. 1 & Roof of Gallery No.7, Library, Second Floor Approx. Width = 2.5mm, Approx. Length = 3.5m. Distance from Wall no.3 = 2.5m, Height from Floor = 0.3m.

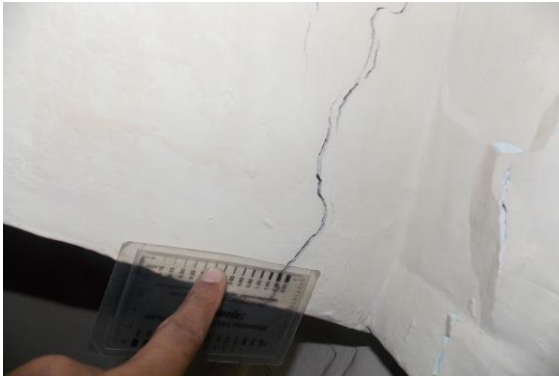
Photo 65

Inclined Crack on Wall No. 4 & Roof of Gallery No.8, Library, Second Floor Approx. Width = 2mm, Approx. Length = 2.5m. Distance from Wall no.1 = 0.15m, Height from Floor = 1m.

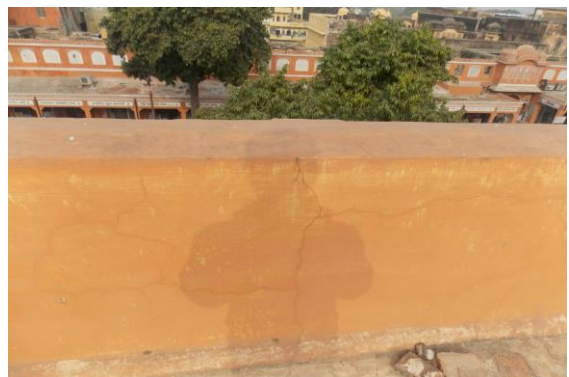
Photo 66A

Inclined Crack on Library, Terrace Approx. Width = 0.5mm, Approx. Length = 1m. Distance from = m, Height from Floor = m.

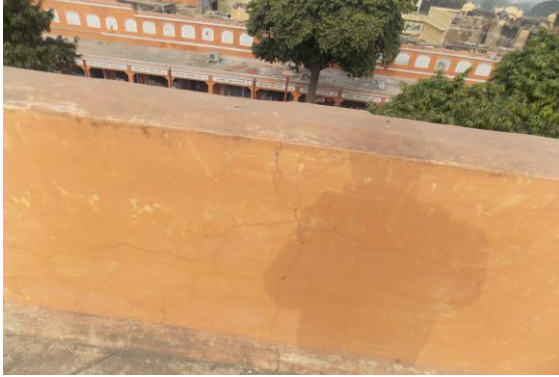
Photo 67

Inclined Crack on Parapet walls of Library, Terrace Approx. Width = 0.5mm, Approx. Length = 2m. Distance from = m, Height from Floor = m.

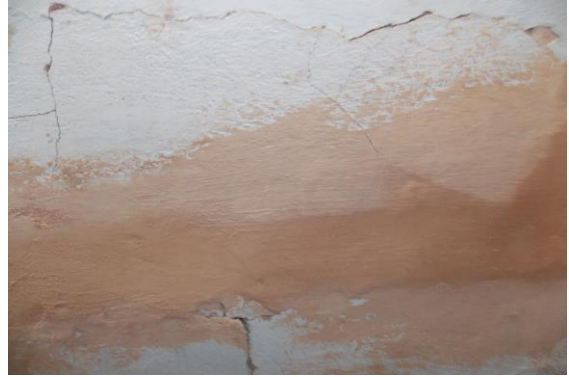
Photo 67A

Inclined Crack on Parapet walls of Library, Terrace
Approx. Width = 0.5mm, Approx. Length = 2m.
Distance from = m, Height from Floor = m.

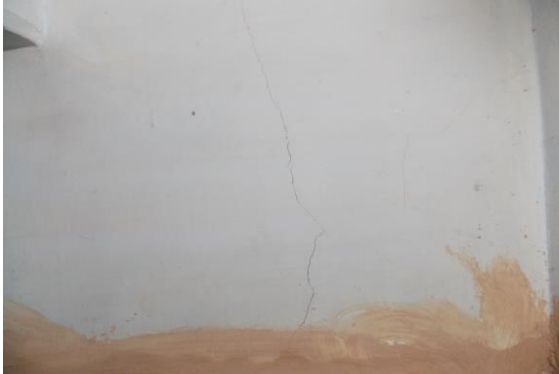
Photo 68

Inclined Crack on of Staircase FF to SF, Terrace
Approx. Width = 2.5mm, Approx. Length = 2m.
Distance from = m, Height from Floor = m.

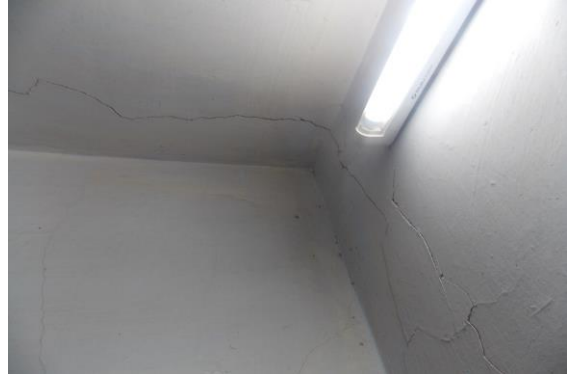
Photo 69

Inclined Crack on Wall No. 1 of Staircase FF to SF, Terrace
Approx. Width = 0.5mm, Approx. Length = 2m.
Distance from = m, Height from Floor = m.

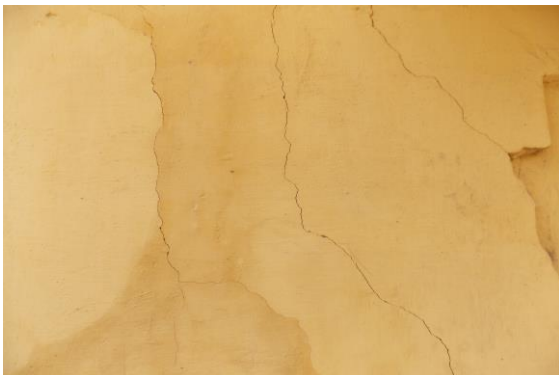
Photo 69A

Inclined Crack on Wall No. 1 of Staircase FF to SF, Terrace
Approx. Width = 0.5mm, Approx. Length = 2m.
Distance from = m, Height from Floor = m.

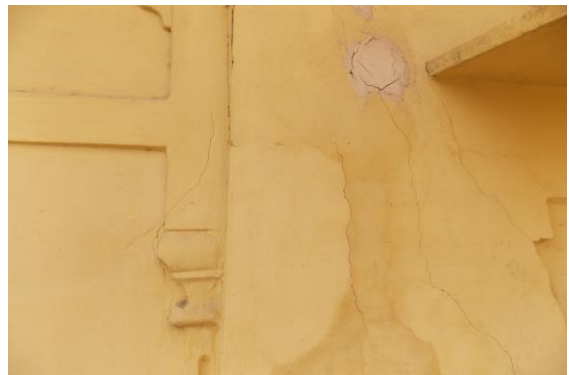
Photo 70

Inclined Crack on Wall No. 3 of Terrace Area, Second Floor
Approx. Width = 0.6mm, Approx. Length = 4.5m.
Distance from Wall no.1 = 1.3m, Height from Floor = 0m.

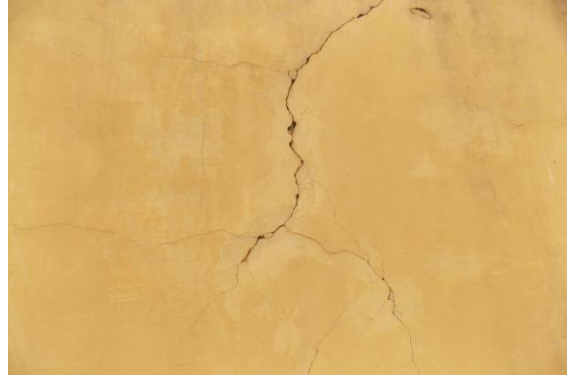
Photo 70A

Inclined Crack on Wall No. 3 of Terrace Area, Second Floor
Approx. Width = 0.6mm, Approx. Length = 4.5m.
Distance from Wall no.1 = 1.3m, Height from Floor = 0m.

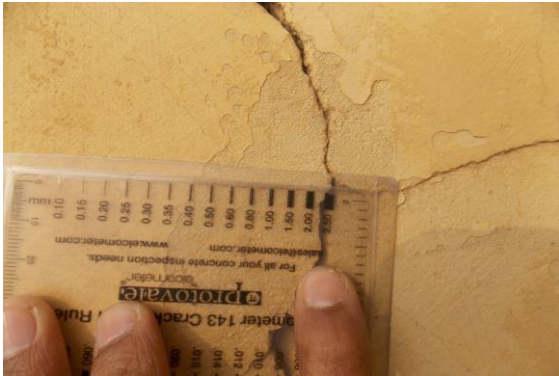
Photo 71

Inclined Crack on Wall No. 1 of Open Sky , Second Floor
Approx. Width = 2.5mm, Approx. Length = 3.5m.
Distance from Wall no.3 = 5.5m, Height from Floor = 0m.

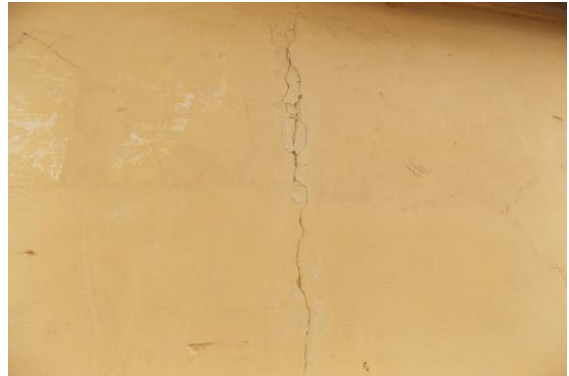
Photo 71A

Inclined Crack on Wall No. 1 of Open Sky , Second Floor
Approx. Width = 2.5mm, Approx. Length = 3.5m.
Distance from Wall no.3 = 5.5m, Height from Floor = 0m.

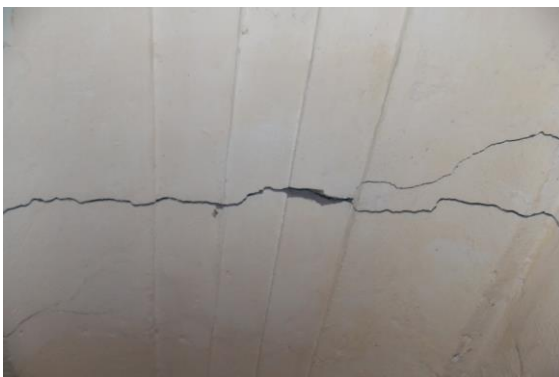
Photo 72

Inclined Crack on Wall No. 4 of Open sky, Second Floor
Approx. Width = 2mm, Approx. Length = 2m.
Distance from = m, Height from Floor = m.

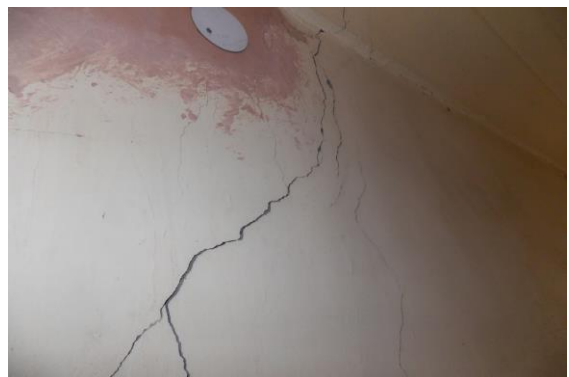
Photo 73

Inclined Crack on of Gallery No.4, Second Floor
Approx. Width = 2mm, Approx. Length = 2m.
Distance from = m, Height from Floor = m.

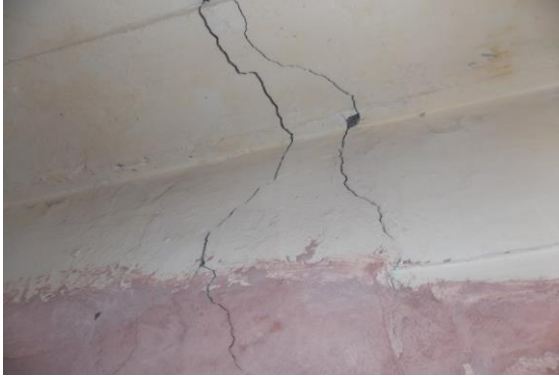
Photo 73A

Inclined Crack on of Gallery No.4, Second Floor
Approx. Width = 2mm, Approx. Length = 2m.
Distance from = m, Height from Floor = m.

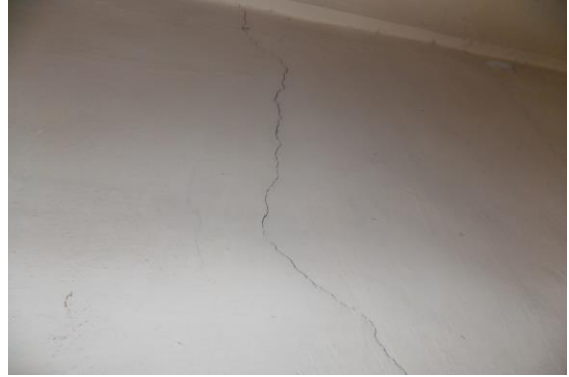
Photo 73A
Inclined Crack on Wall No. 1 of Gallery No. 4, Second Floor
Approx. Width = 2mm, Approx. Length = 2m.
Distance from Wall no. 3 = 3.2m, Height from Floor = 0.7m.

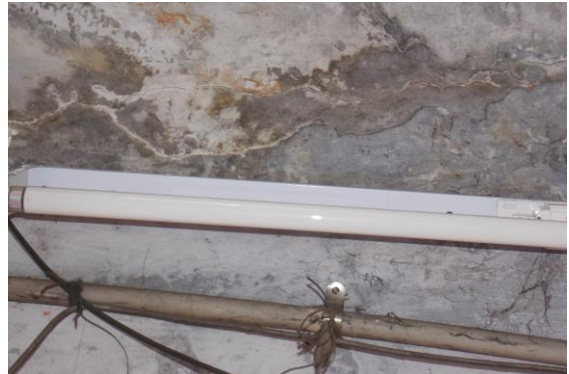
Photo 74A
Inclined Crack on Wall No. 1 of Gallery No. 4, Second Floor
Approx. Width = 0.6mm, Approx. Length = 2.1m.
Distance from Wall no. 3 = 3.2m, Height from Floor = 0.7m.
