Pre Building Condition Survey Report

Name and Address of Structure :	Choti Chopar to Badi Chopar (Down Line)
---------------------------------	---

Name of the Project	Contract JMRC-UG1B “Design and Construction of Tunnel between Chandpole and Badi Chouper and reverse line by Shield TBM, Underground Metro Stations at Choti Chouper and Badi Chouper by Cut and Cover Methods on East West Corridor of Jaipur Metro Rail Corporation Limited .”	
Owner :

Pre Building Condition Survey Report Choti Chopar to Badi Chopar (Down Line)

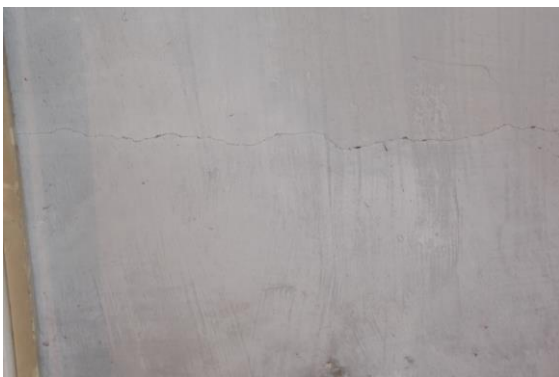
Photo 75
Horizontal Crack on Roof of Varanda of Shop No. 283 A, G/F Approx.
Width = 0.6mm, Approx. Length = 2.5m. Distance from Leftside External Column = Backsidem, Height from Floor = 3m.

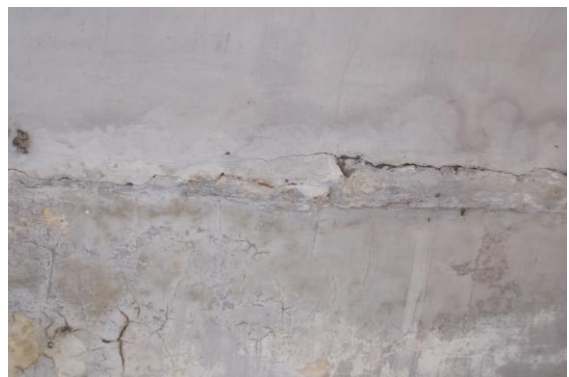
Photo 76
Horizontal Crack on Roof of Varanda of Shop No. 282, Ground Floor
Approx. Width = 0.2mm, Approx. Length = 2.2m. Distance from Leftside External Column = 1.2m, Height from Floor = 3m.

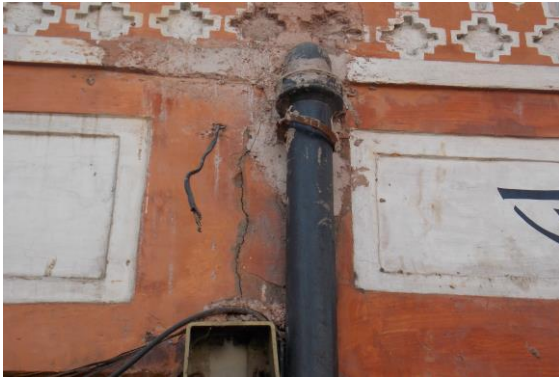
Photo 77
Horizontal Crack on Roof of Varanda of Shop No. 282, Ground Floor
Approx. Width = 1mm, Approx. Length = 2.5m. Distance from Leftside External Column = Backsidem, Height from Floor = 3m.

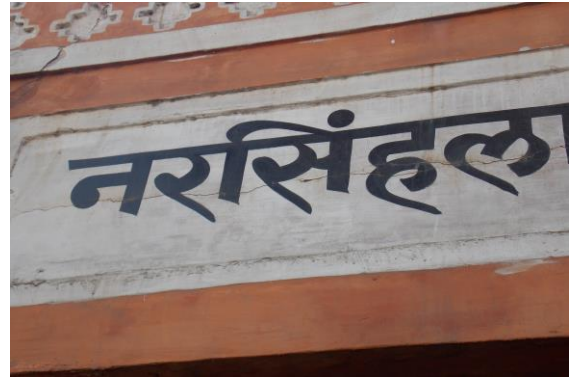
Photo 78

Vertical Crack on Rightside external Column of Varanda of Shop No.279, Ground Floor Approx. Width = 1mm, Approx. Length = 1.1m. Distance from = m, Height from Floor = 2.5m.

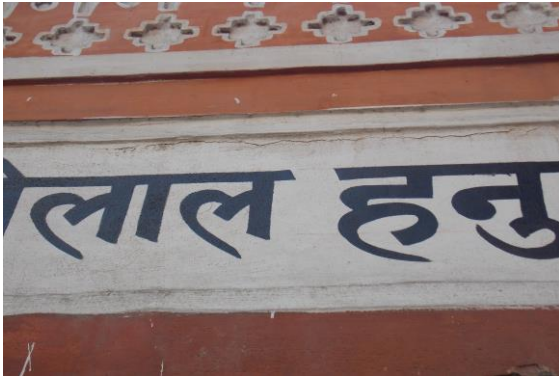
Photo 79

Horizontal Crack on External Beam of Varanda of Shop No.277, G/F Approx. Width = 0.35mm, Approx. Length = 2m. Distance from Leftside External Column = 0m, Height from Floor = 2.5m.

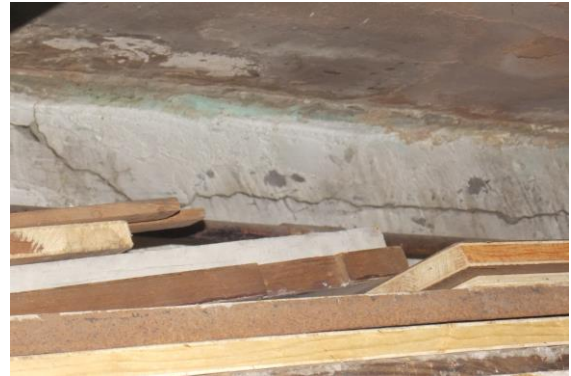
Photo 80

Inclined Crack on External Beam of Varanda of Shop No.276, G/F Approx. Width = 0.4mm, Approx. Length = 2.1m. Distance from Leftside External Column = 0.7m, Height from Floor = 3m.

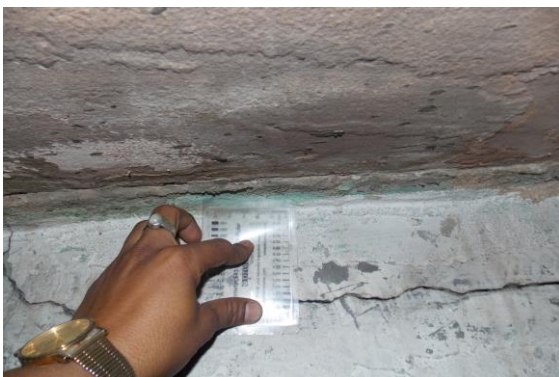
Photo 81

Inclined Crack on Wall No. 1 of Part B of Shop No.210, Upper Ground Floor Approx. Width = 2mm, Approx. Length = 2m. Distance from Wall No.4 = 0m, Height from Floor = 1.6m.

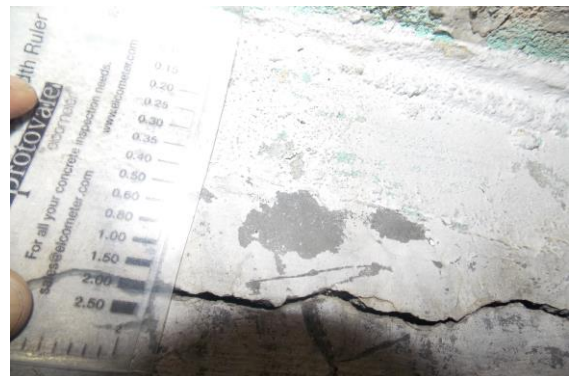
Photo 81A

Inclined Crack on Wall No. 1 of Part B of Shop No.210, Upper Ground Floor Approx. Width = 2mm, Approx. Length = 2m. Distance from Wall No.4 = 0m, Height from Floor = 1.6m.

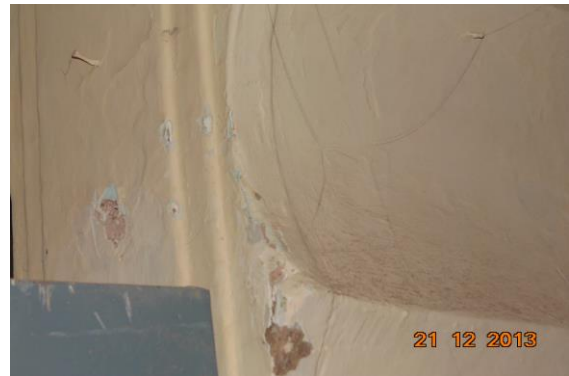
Photo 82

Peeling of Plaster on Wall No. 4 of Library of Library, Ground floor

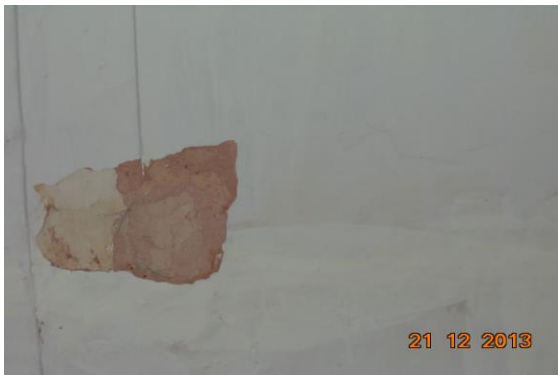
Photo 83

Peeling of Plaster on Wall No. 4 of Varanda No.2 of Library, Ground floor

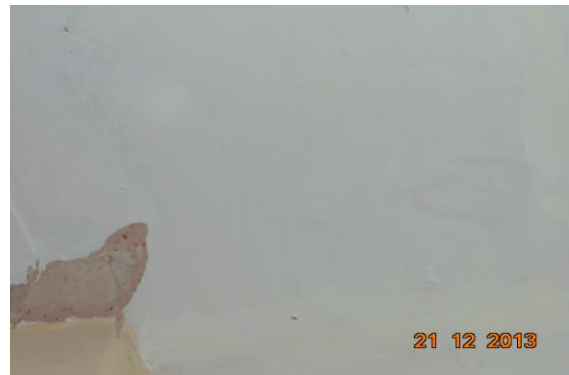
Photo 84

Dampness/Seepage on Roof of Varanda No.3 of Library, Ground floor

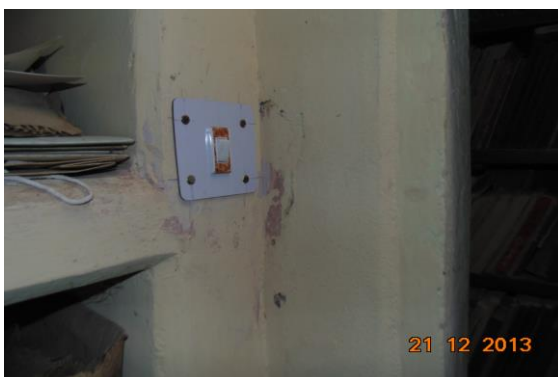
Photo 85

Dampness/Seepage on Roof of Varanda No.3 of Library, Ground floor

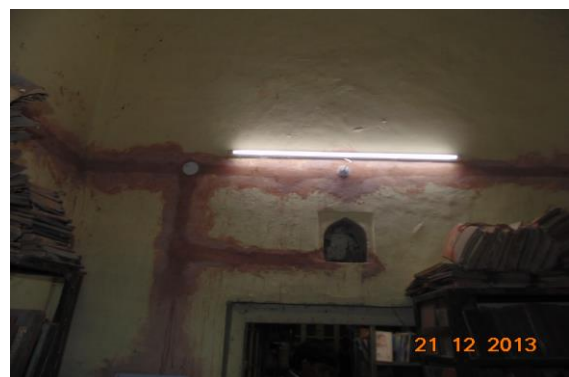
Photo 86

Peeling of Plaster on Wall No. 4 of Room No. 2 of Library, Ground floor

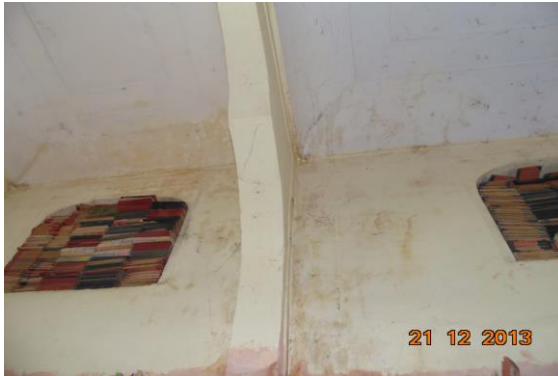
Photo 87

Peeling of Plaster on Wall No. 3 of Room No. 1 of Library, Ground floor

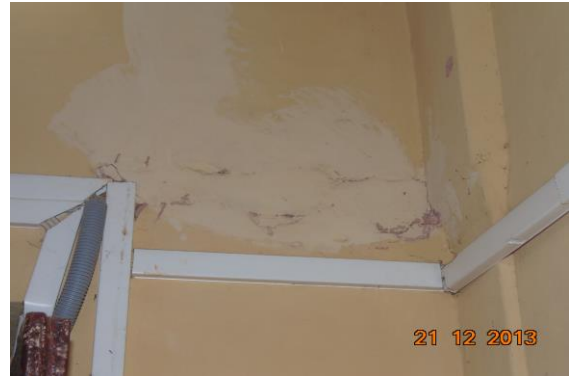
Photo 88

Dampness/Seepage on Roof & 2 of Room No. 1 of Library, Ground floor

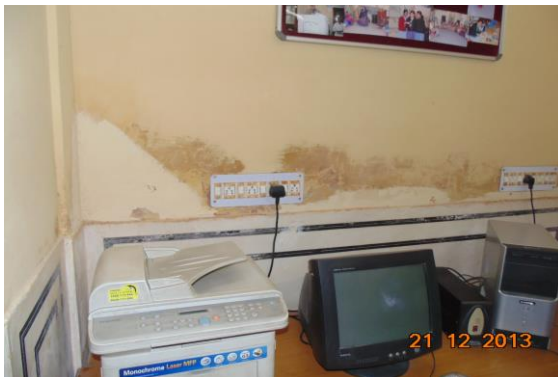
Photo 89

Peeling of Plaster on Wall No. 3 of Room No. 4 of Library, Ground floor

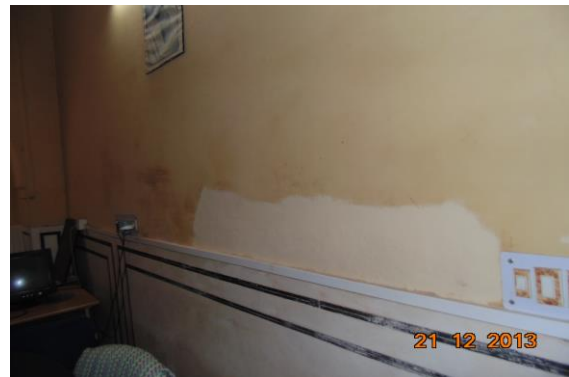
Photo 90

Dampness/Seepage on Wall No. 4 of Room No. 4 of Library, Ground floor

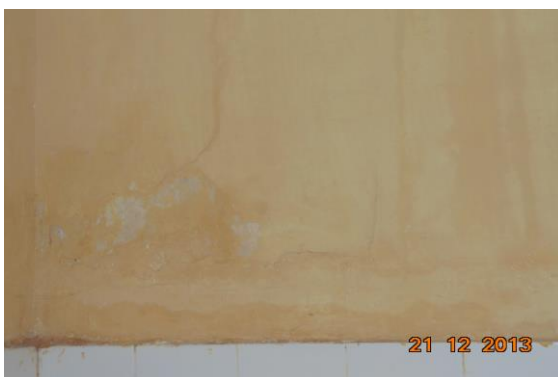
Photo 91

Peeling of Plaster on Wall No. 3 of Room No. 4 of Library, Ground floor

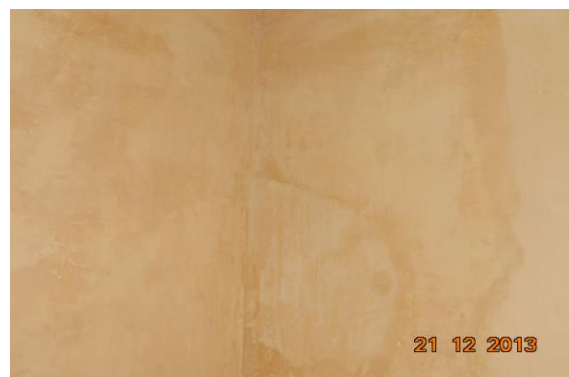
Photo 92

Dampness/Seepage on Wall No. 2 of Toilet No. 1 of Library, Ground floor

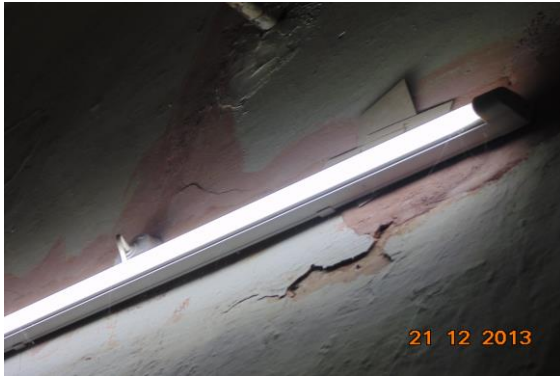
Photo 93

Dampness/Seepage on Wall No. 2 & 4 of Bathroom of Library, Ground floor

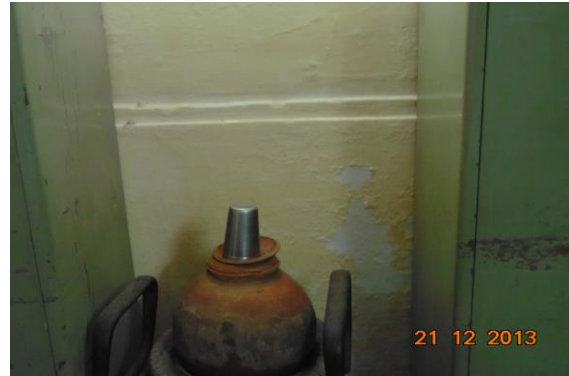
Photo 94

Peeling of Plaster on Wall No. 3 of Room No. 4 of Library, Ground floor

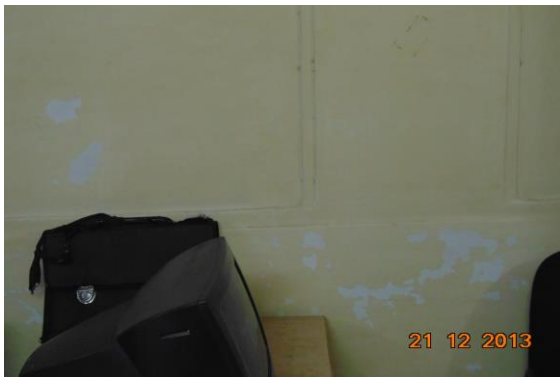
Photo 95

Dampness/Seepage on Wall No. 4 of Room No. 6 of Library, Ground floor

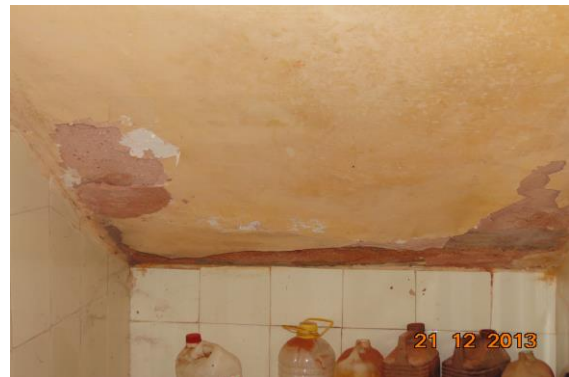
Photo 96

Peeling of Plaster on Wall No. 1 of Room No. 6 of Library, Ground floor

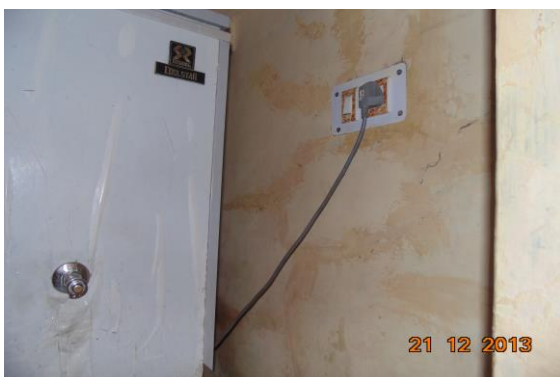
Photo 97

Damaged Portion on Roof of Toilet No. 2 of Library, Ground floor

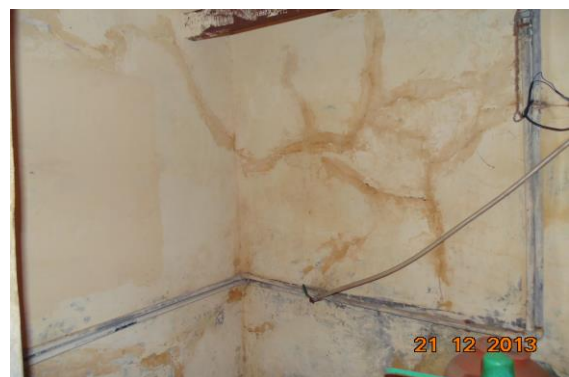
Photo 98

Dampness/Seepage on Wall No. 2 of Library of Ground floor

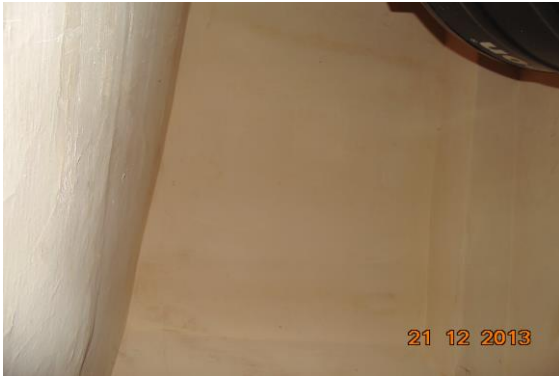
Photo 99

Damaged Portion on Wall No. 4 & 1 of Library of Ground floor

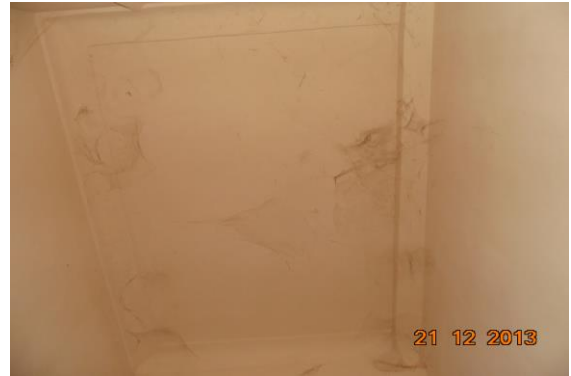
Photo 100
Dampness/Seepage on Roof of Library of Ground floor

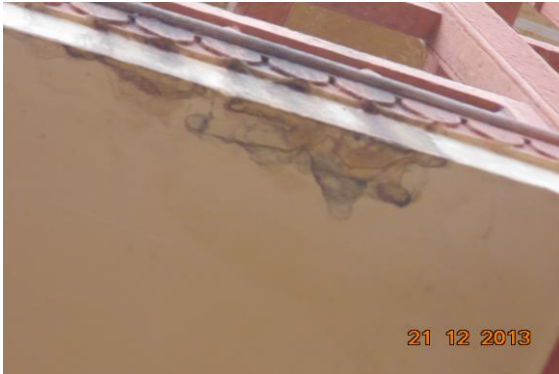
Photo 101
Dampness/Seepage on Roof of Toilet No. 3 of Library, Ground floor

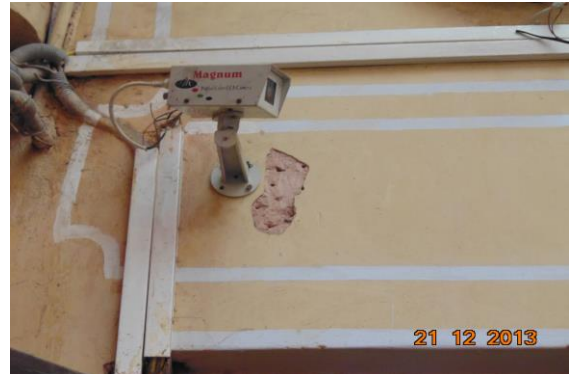
Photo 102
Damaged Portion on Wall No. 2 & Shade of Open sky area of Library, Ground floor

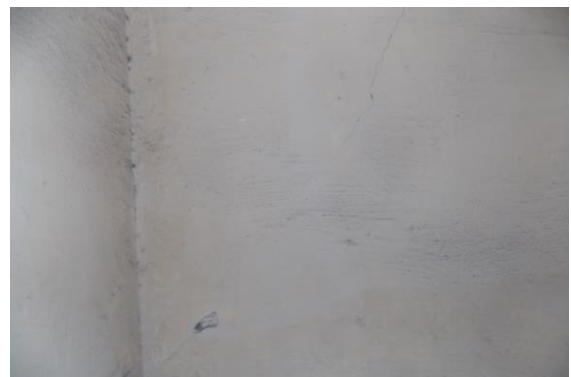
Photo 104
Peeling of Plaster on Wall No. 1 of Open sky area of Library, Ground floor

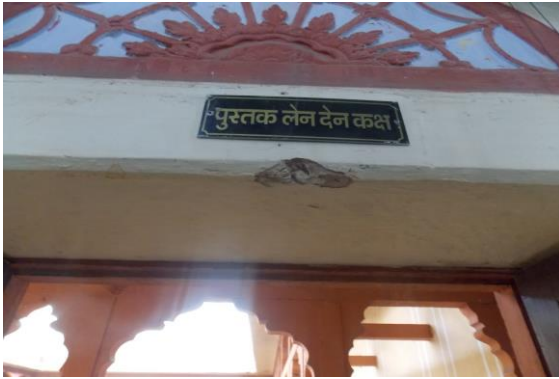
Photo 106

Damaged Portion on Wall No. 3 of Hall No. 1 of Library, First Floor

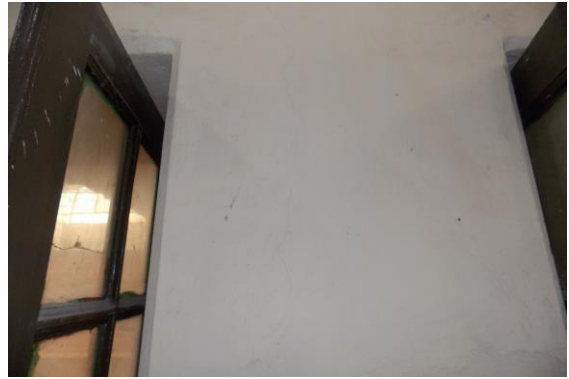
Photo 107

Peeling of Plaster on Wall No. 3 of Hall No. 1 of Library, First Floor

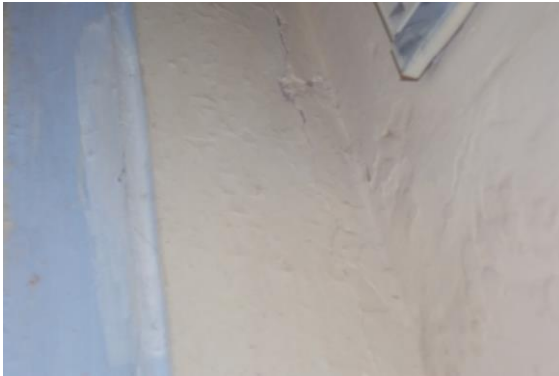
Photo 108

Peeling of Plaster on Wall No. 3 of Hall No. 1 of Library, First Floor

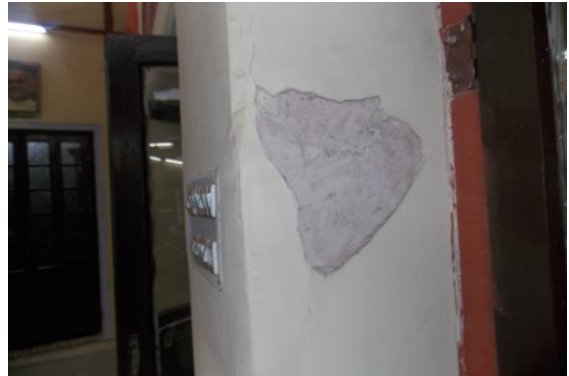
Photo 109

Damaged Portion on Wall No. 3 of Hall No. 1 of Library, First Floor

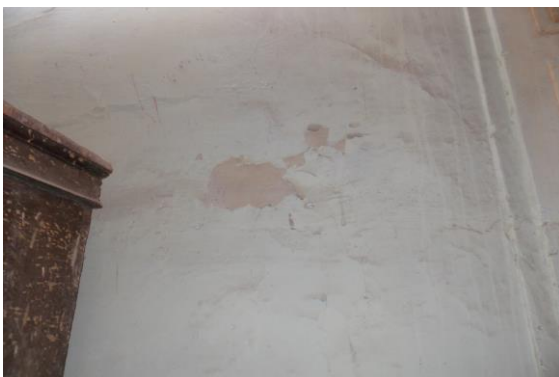
Photo 110

Peeling of Plaster on Wall No. 3 of Hall No. 2 of Library, First Floor

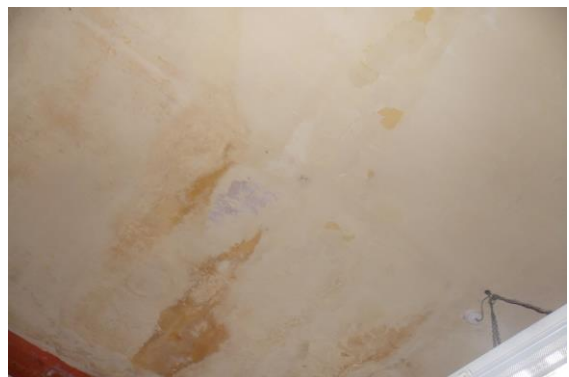
Photo 111

Dampness/Seepage on Roof of Hall No. 3 of Library, First Floor

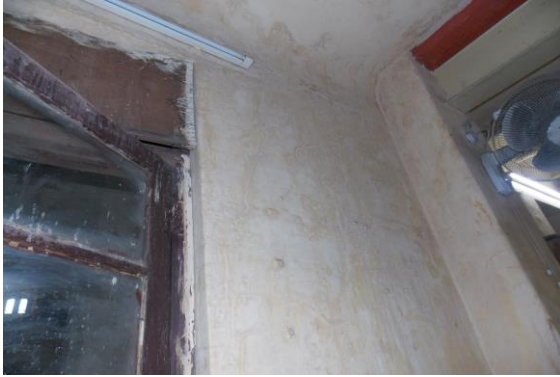
Photo 112

Dampness/Seepage on Wall No. 1 of Hall No. 3 of Library, First Floor

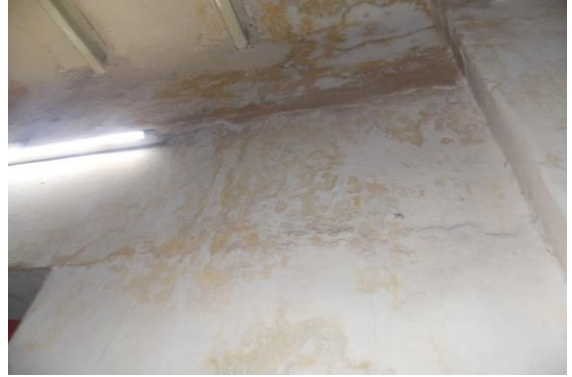
Photo 113

Dampness/Seepage on Wall No. 2 of Hall No. 3 of Library, First Floor

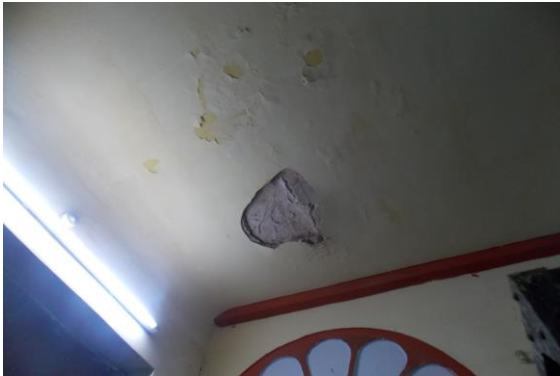
Photo 114

Damaged Portion on Roof of Hall No. 2 of Library, First Floor

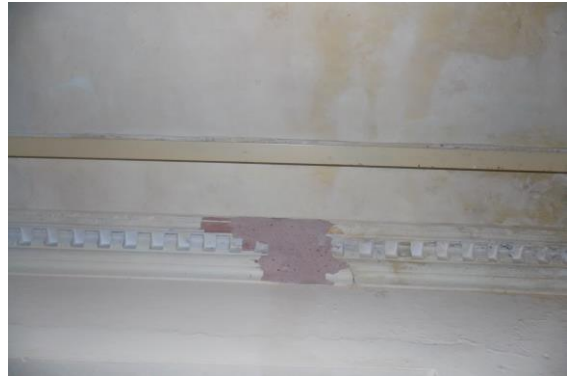
Photo 115

Damaged Portion on Roof of Passage No.2 of Library, First Floor

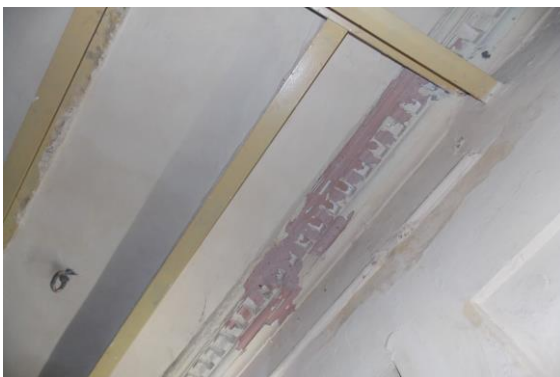
Photo 116

Peeling of Plaster on Roof of Passage No.2 of Library, First Floor

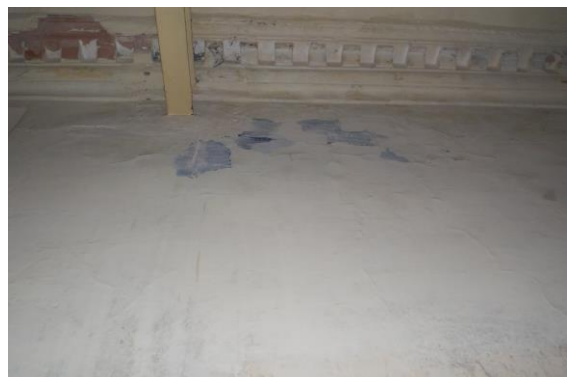
Photo 117

Peeling of Plaster on Wall No. 4 of Passage No.2 of Library, First Floor

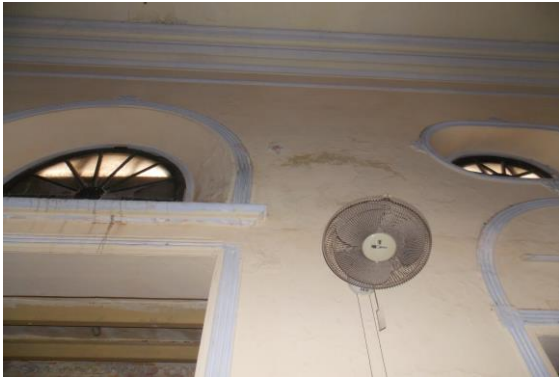
Photo 118

Dampness/Seepage on Wall No. 3 of Hall No. 4 of Library, First Floor

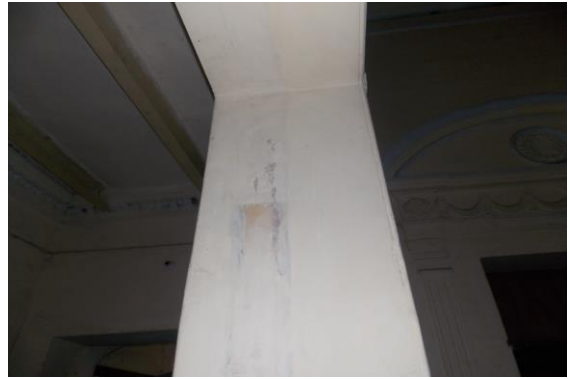
Photo 119

Peeling of Plaster on Outer Wall Main gate of Hall No. 4 of Library, First Floor

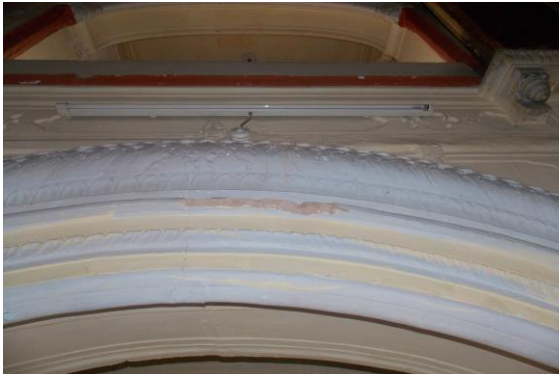
Photo 120

Peeling of Plaster on Wall No. 4 of Hall No. 4 of Library, First Floor

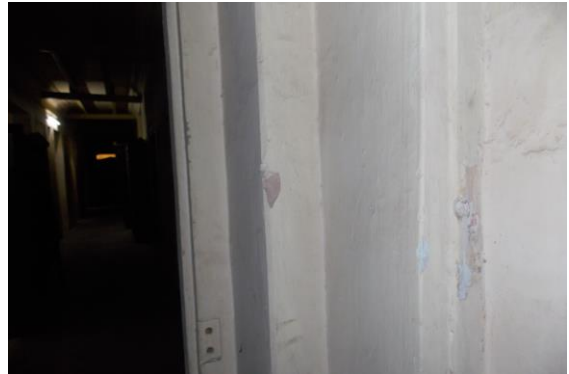
Photo 121

Peeling of Plaster on Wall No. 3 of Passage of Library, First Floor

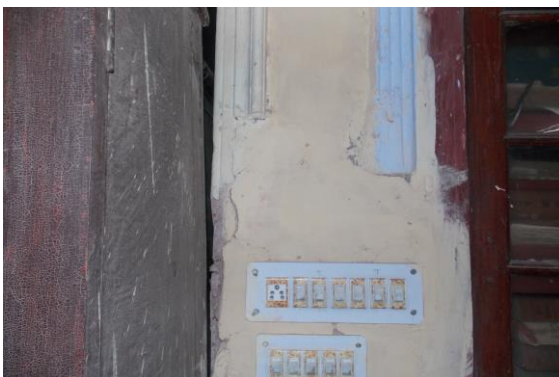
Photo 122

Peeling of Plaster on Wall No. 1 of Hall No. 5 of Library, First Floor

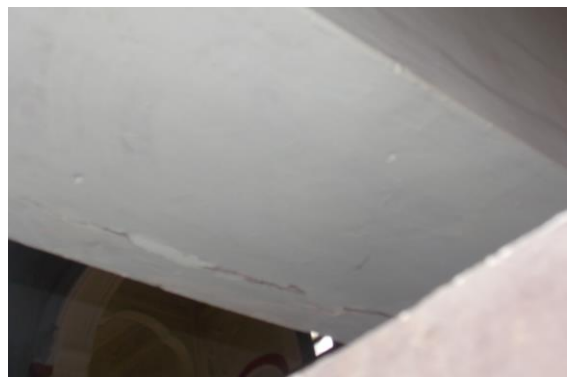
Photo 123

Peeling of Plaster on Wall No. 1 & Roof of Hall No. 5 of Library, First Floor

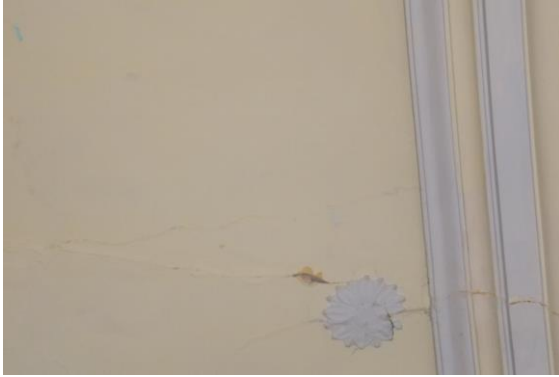
Photo 124
Peeling of Plaster on Roof of Hall No. 5 of Library, First Floor

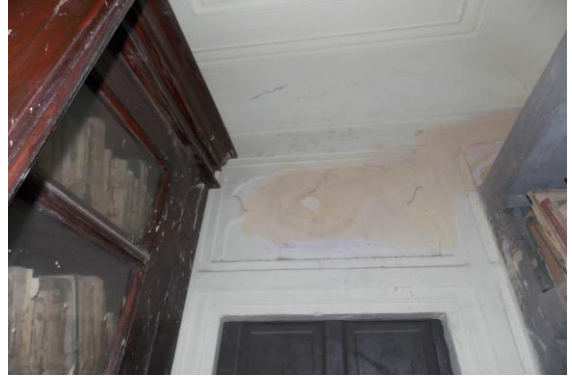
Photo 125
Dampness/Seepage on Roof & 4 of Passage No.3 of Library, First Floor

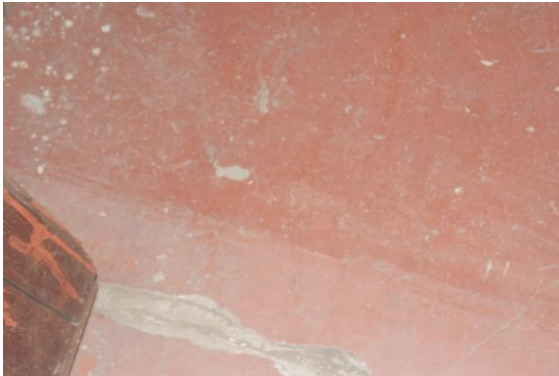
Photo 126
Peeling of Plaster on Floor of Hall No. 5 of Library, First Floor

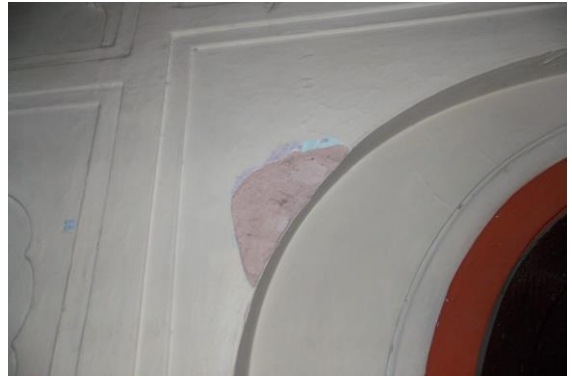
Photo 127
Peeling of Plaster on Wall No. 4 of Hall No. 5 of Library, First Floor

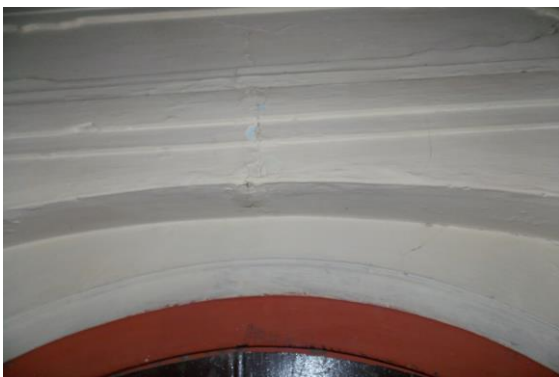
Photo 128
Peeling of Plaster on Wall No. 4 of Hall No. 5 of Library, First Floor

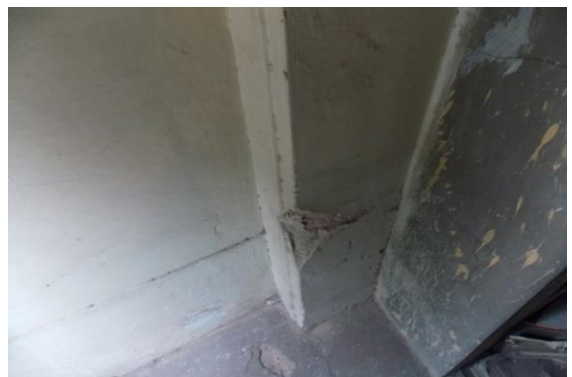
Photo 129
Damaged Portion on Wall No. 2 of Hall No. 5 of Library, First Floor

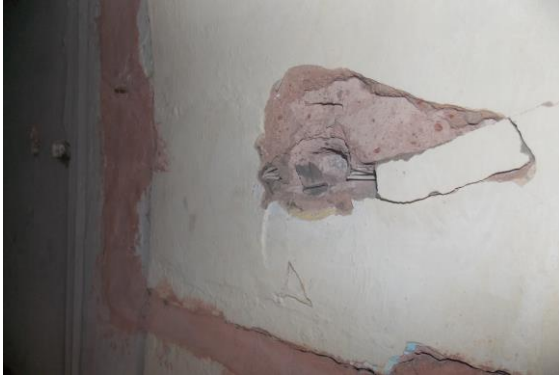
Photo 130

Exposed Reinforcement on Wall No. 2 of Gallery No.2 of Library, First Floor

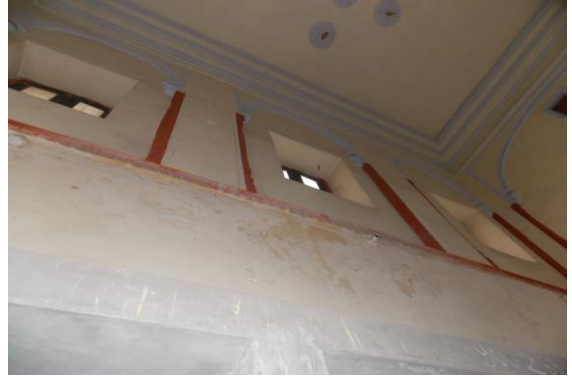
Photo 131

Peeling of Plaster on Wall No. 1 of Hall No. 6 of Library, First Floor

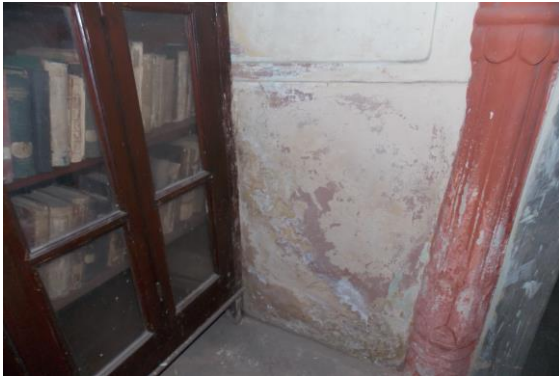
Photo 132

Peeling of Plaster on Wall No. 1 of Hall No. 6 of Library, First Floor

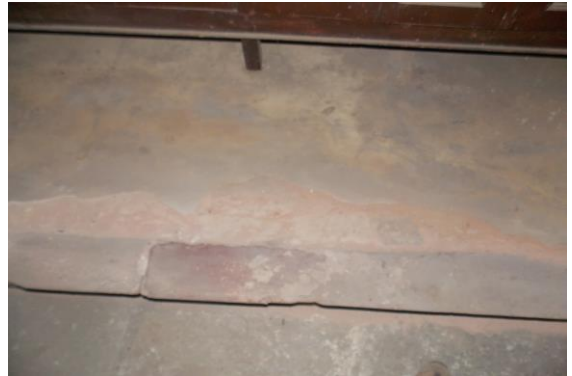
Photo 133

Peeling of Plaster on Floor of Hall No. 6 of Library, First Floor

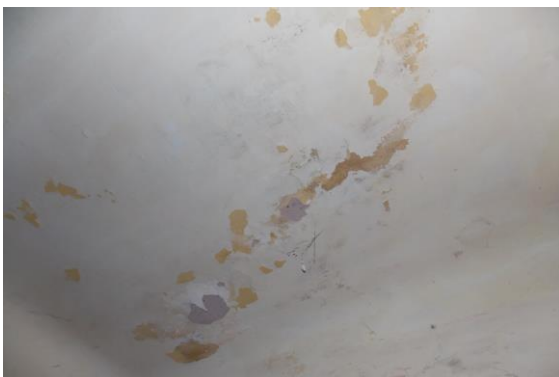
Photo 134

Dampness/Seepage on Roof of Hall No. 7 of Library, First Floor

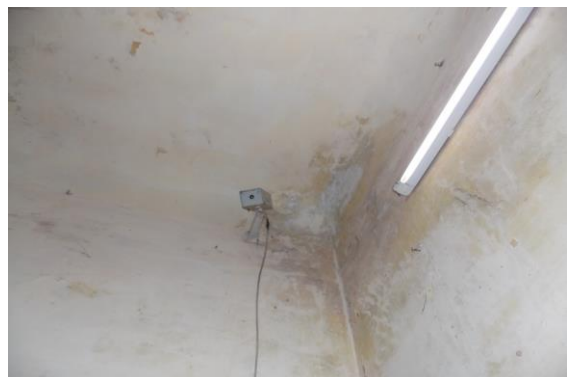
Photo 135

Dampness/Seepage on Wall No. 2, 4 & Roof of Hall No. 7 of Library, First Floor

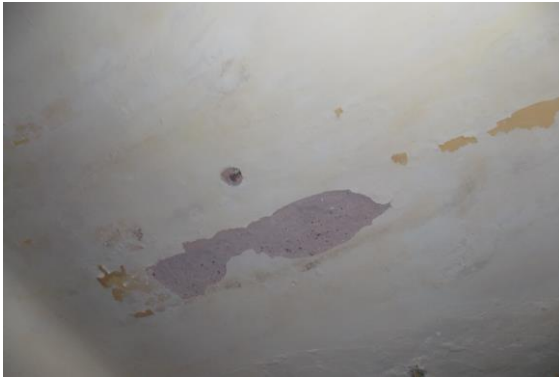
Photo 136
Peeling of Plaster on Roof of Hall No. 7 of Library, First Floor

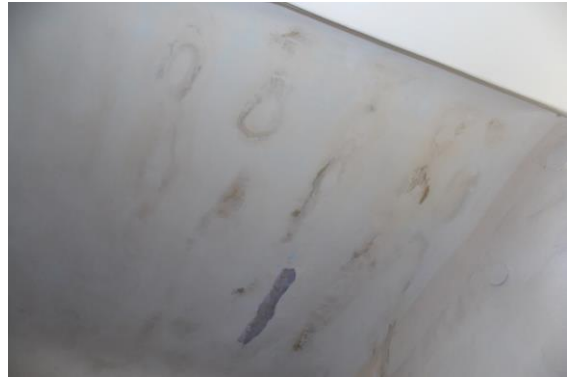
Photo 137
Peeling of Plaster on Roof of Hall No. 8 of Library, First Floor

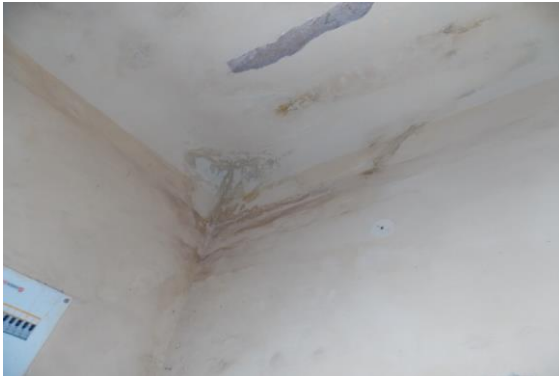
Photo 138
Dampness/Seepage on Wall No. 2, 3 & Roof of Hall No. 8 of Library, First Floor

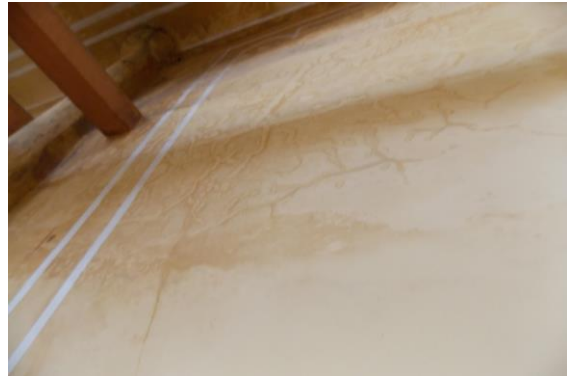
Photo 139
Dampness/Seepage on Wall No. 3 of Balcony of Library, First Floor

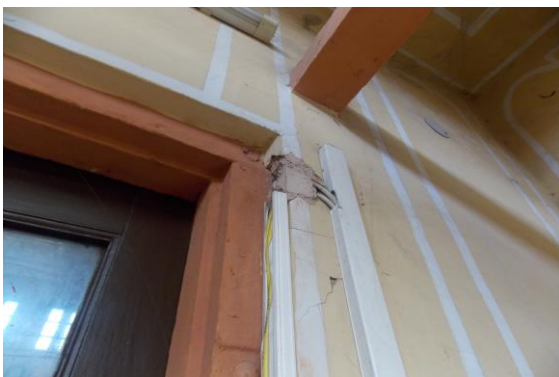
Photo 140
Damaged Portion on Wall No. 1 of Balcony of Library, First Floor

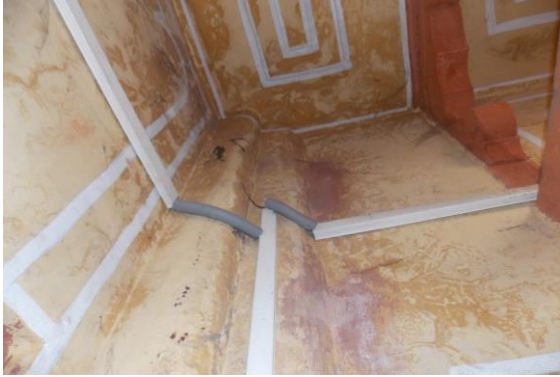
Photo 142

Dampness/Seepage on Wall No. 2, 3 & Roof of Balcony of Library, First Floor

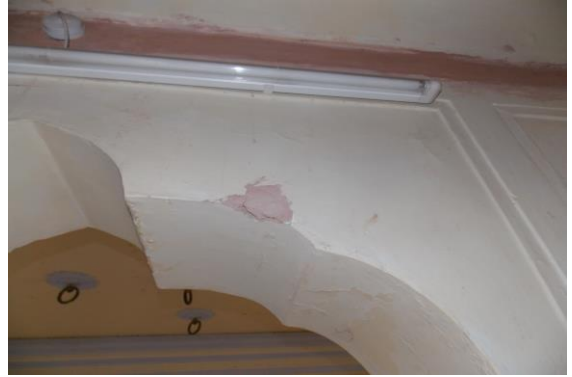
Photo 143

Damaged Portion on Wall No. 1 of Gallery No.1 of Library, Second Floor

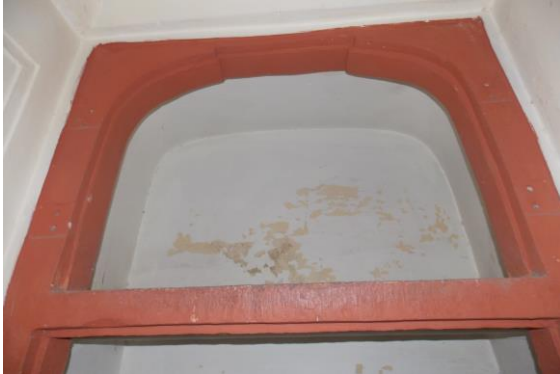
Photo 144

Peeling of Plaster on Wall No. 4 of of Library, Second Floor

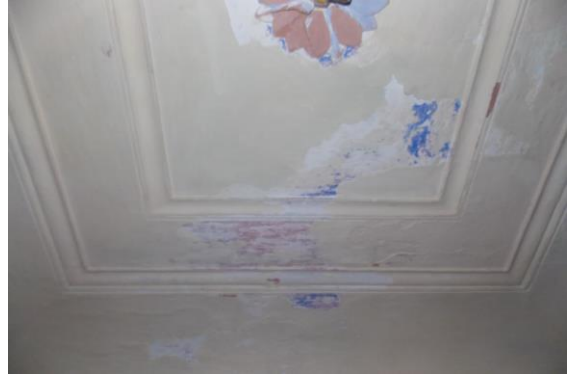
Photo 145

Peeling of Plaster on Roof of Balcony of Library, Second Floor

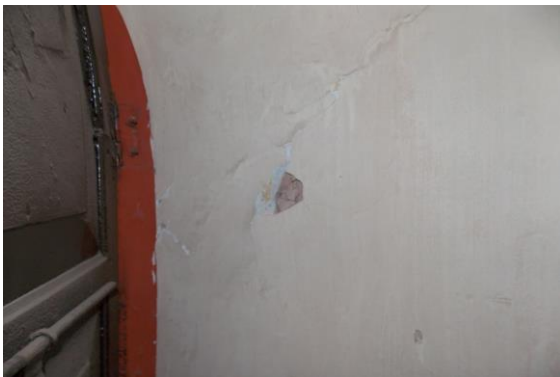
Photo 146

Peeling of Plaster on Wall No. 2 of Balcony of Library, Second Floor

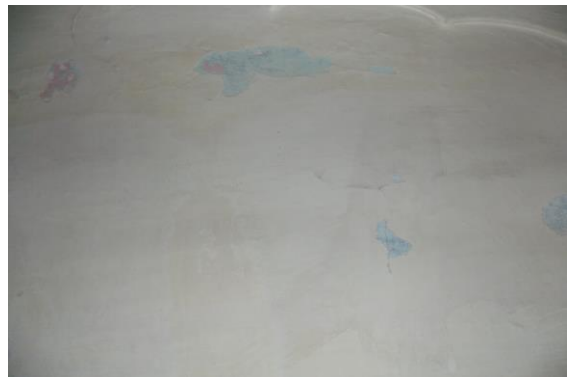
Photo 147

Peeling of Plaster on Wall No. 1 of Gallery No.3 of Library, Second Floor

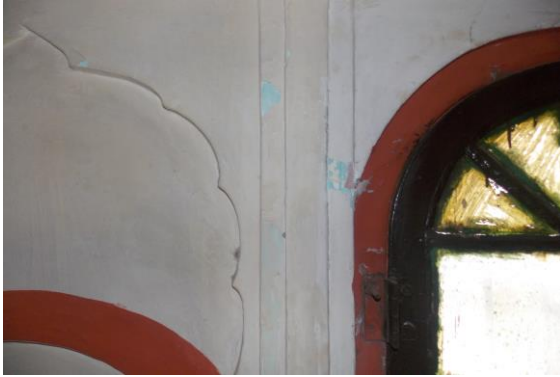
Photo 148

Peeling of Plaster on Wall No. 1 of Gallery No.5 of Library, Second Floor

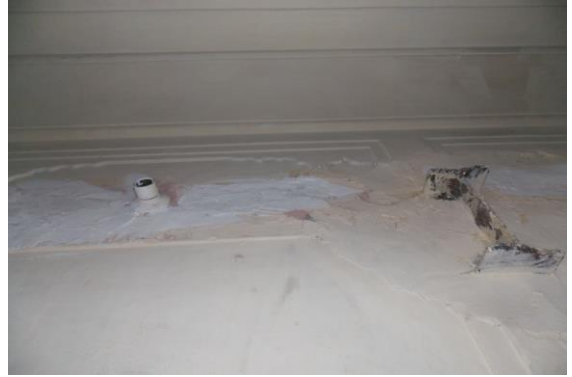
Photo 149

Peeling of Plaster on Wall No. 2 of Gallery No.7 of Library, Second Floor

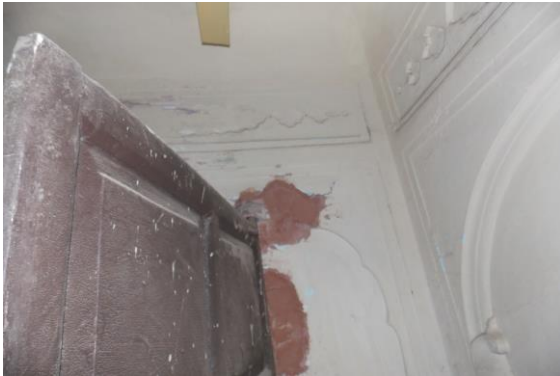
Photo 150

Peeling of Plaster on Wall No. 3 of Gallery No.8 of Library, Second Floor

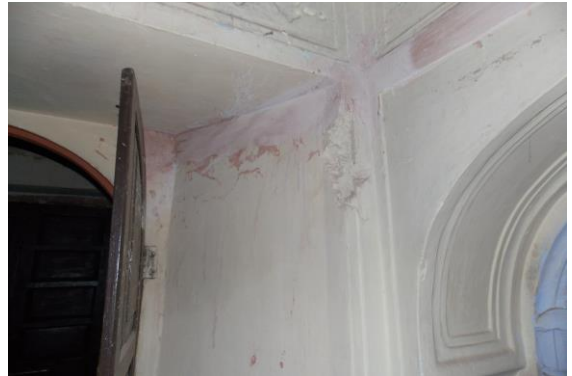
Photo 151

Peeling of Plaster on Wall No. 4 of Gallery no.8 of Library, Second Floor

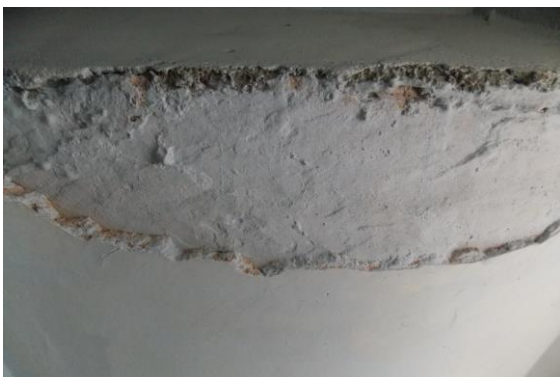
Photo 152

Damaged Portion on of Staircase FF to SF of Terrace

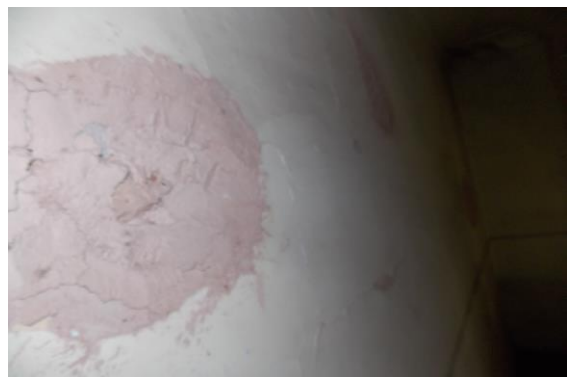
Photo 153

Peeling of Plaster on Wall No. 4 of Gallery No.4 of Second Floor

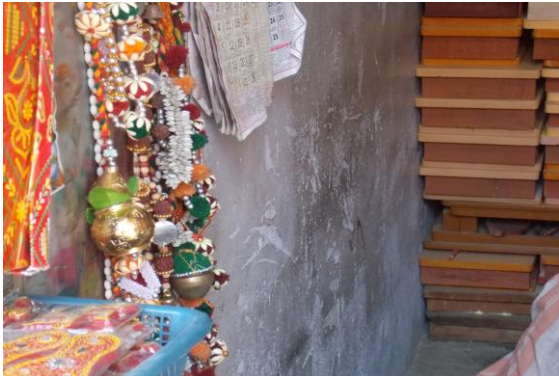
Photo 154
Peeling of Plaster on Wall No. 1 of Shop No.204 B of Ground Floor

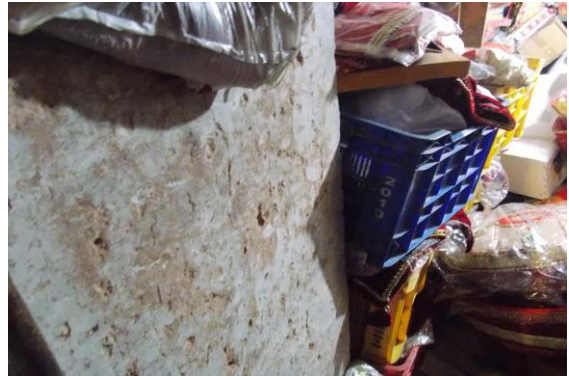
Photo 155
Peeling of Plaster on Wall No. 1 of Part B of Shop No.204 A of Ground Floor

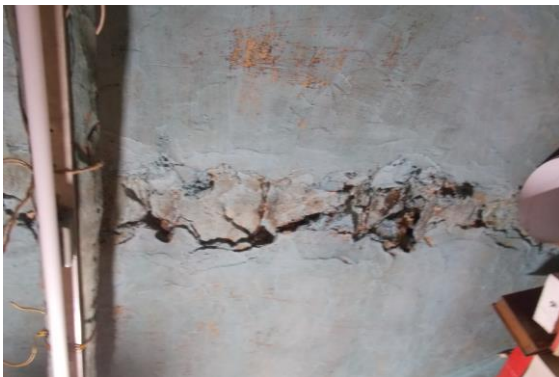
Photo 156
Damaged Portion on Roof of Part B of Shop No.284 of Ground Floor

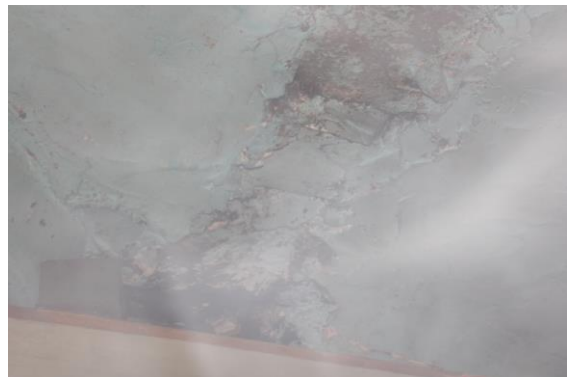
Photo 157
Damaged Portion on Roof of Part B of Shop No.284 of Ground Floor

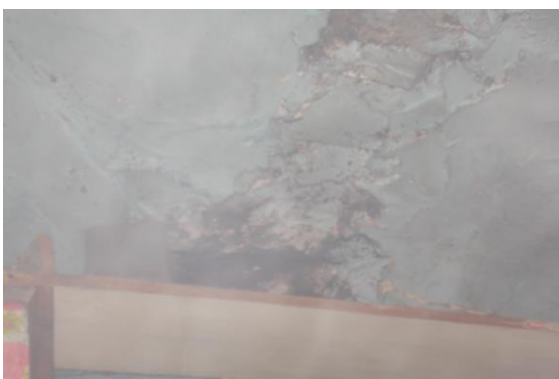
Photo 158
Damaged Portion on Roof of Part B of Shop No.284 of Ground Floor

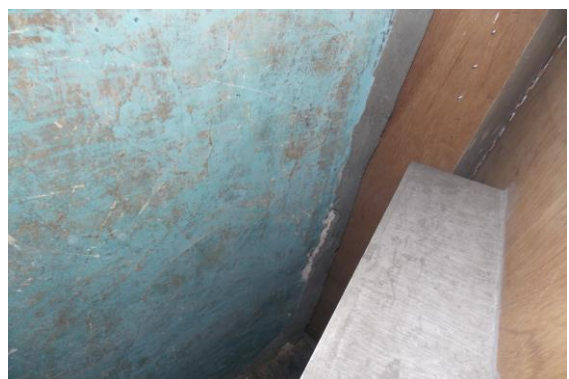
Photo 159
Peeling of Plaster on Wall No. 1 of Part B of Shop No.284 of Ground Floor

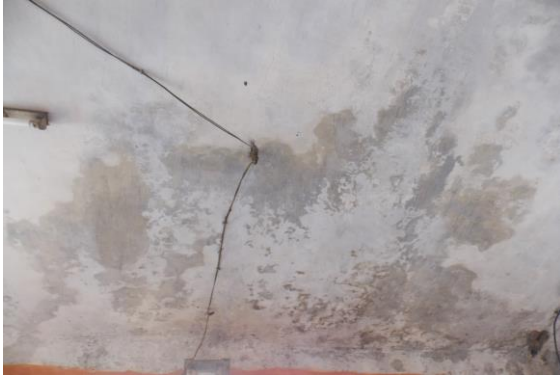
Photo 160

Dampness/Seepage on Roof of Varanda of Shop No.284 of Ground Floor

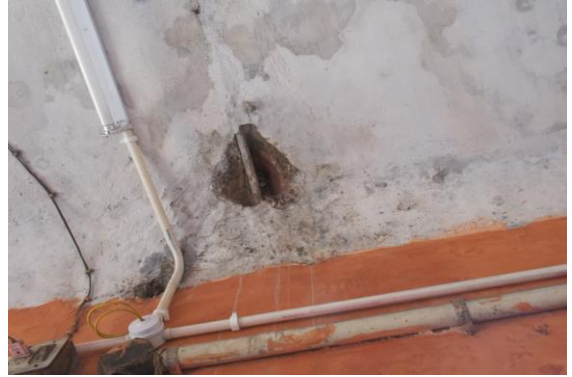
Photo 161

Damaged Portion on Rightside external Column of Varanda of Shop No.284 of Ground Floor

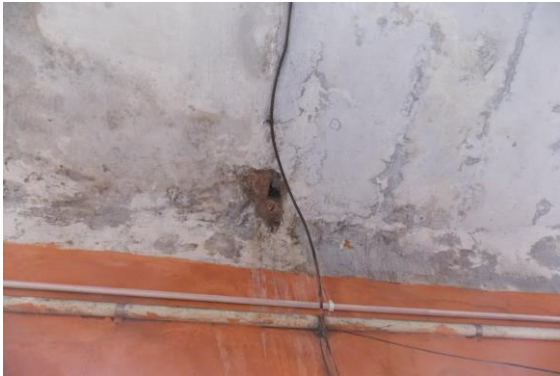
Photo 162

Damaged Portion on Wall Left side Column of Varanda of Shop No.284 of Ground Floor

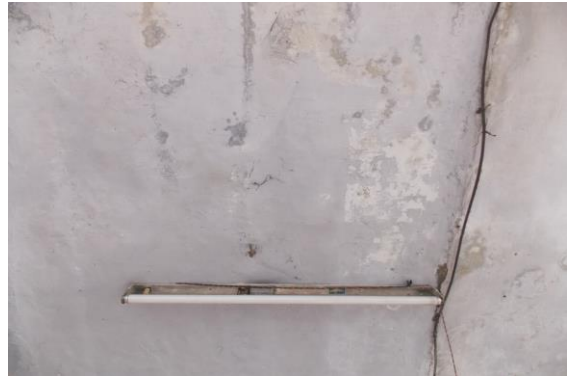
Photo 163

Dampness/Seepage on Roof of Varanda of Shop No.283 B of Ground Floor

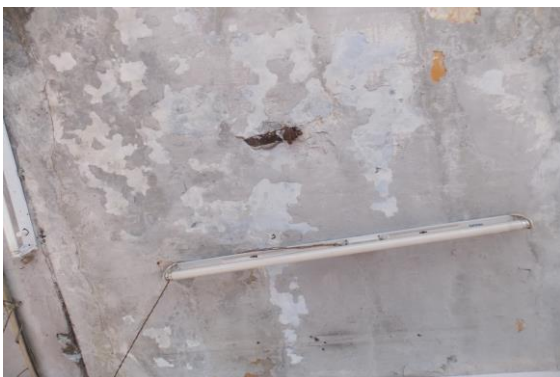
Photo 164

Dampness/Seepage on Roof of Varanda of Shop No.283 A of Ground Floor

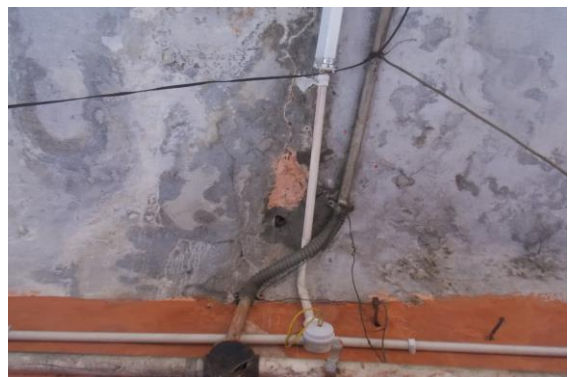
Photo 165

Dampness/Seepage on Roof of Varanda of Shop No.283 A of Ground Floor

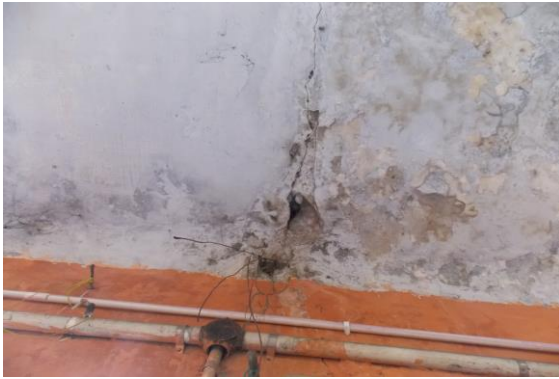
Photo 166

Damaged Portion on Roof of Varanda of Shop No.282 of Ground Floor

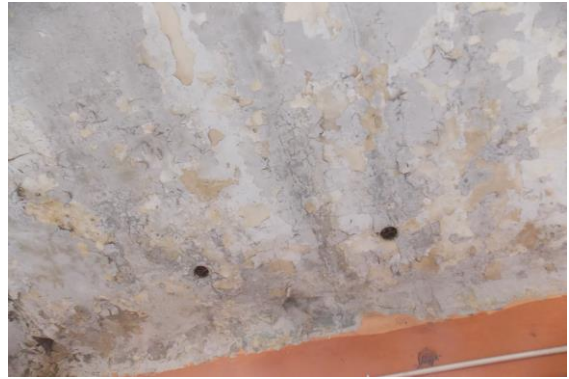
Photo 167

Dampness/Seepage on Roof of Varanda of Shop No.281 of Ground Floor

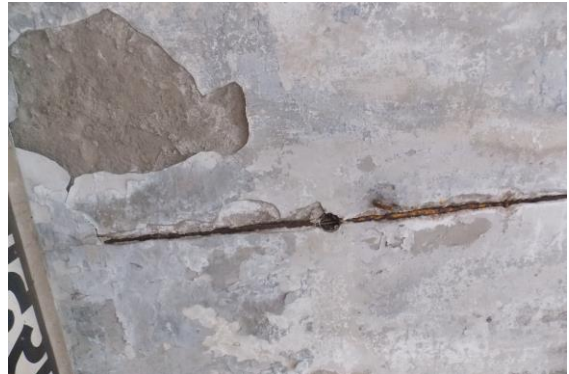
Photo 169

Exposed Reinforcement on Roof of Varanda of Shop No.277 of Ground Floor

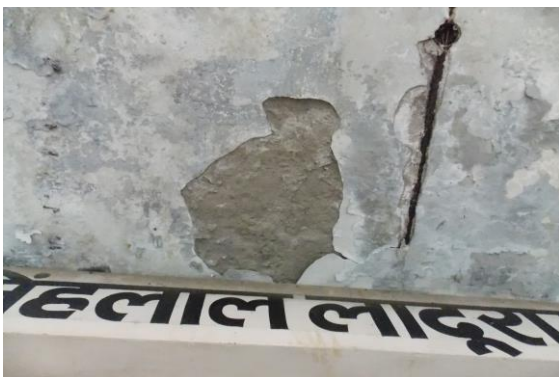
Photo 170

Dampness/Seepage on Roof of Varanda of Shop No.277 of Ground Floor

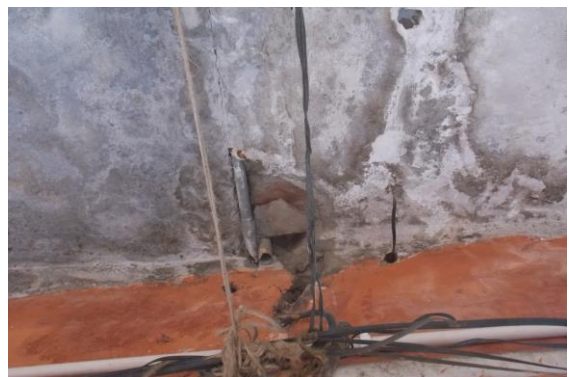
Photo 171

Dampness/Seepage on Roof of Varanda of Shop No.277 of Ground Floor

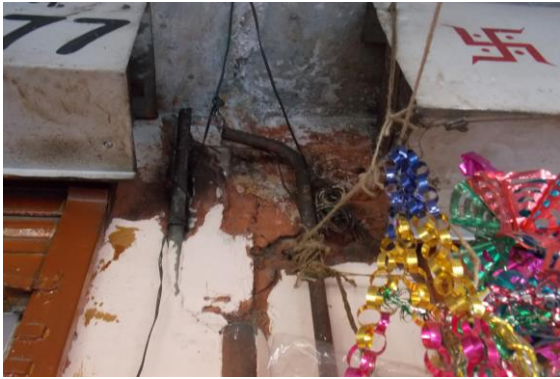
Photo 172

Peeling of Plaster on Right-side external Column of Varanda of Shop No.277 of Ground Floor

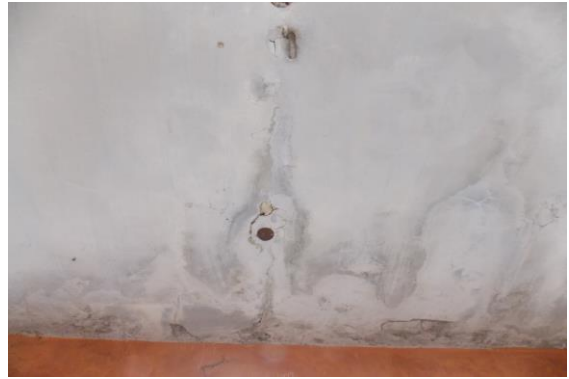
Photo 173

Dampness/Seepage on Roof of Varanda of Shop No.276 of Ground Floor
