Pre Building Condition Survey Report

Name and Address of Structure :	Choti Chopar to Badi Chopar (Down Line)
---------------------------------	---

Name of the Project	Contract JMRC-UG1B “Design and Construction of Tunnel between Chandpole and Badi Chouper and reverse line by Shield TBM, Underground Metro Stations at Choti Chouper and Badi Chouper by Cut and Cover Methods on East West Corridor of Jaipur Metro Rail Corporation Limited .”	
Owner :

Pre Building Condition Survey Report Choti Chopar to Badi Chopar (Down Line)

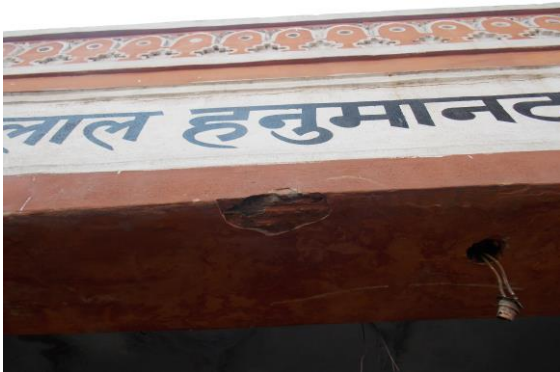
Photo 174

Peeling of Plaster on External Beam of Varanda of Shop No.276 of Ground Floor

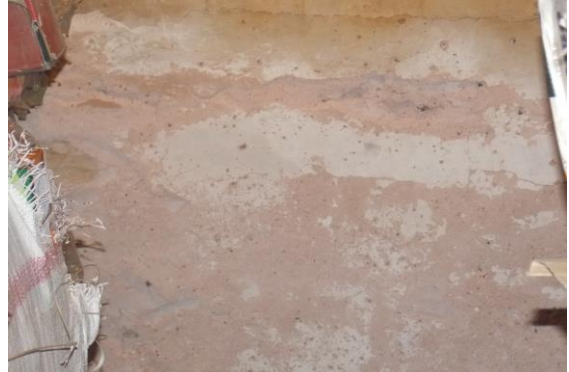
Photo 175

Peeling of Plaster on Roof of Shop No.209 of Ground Floor

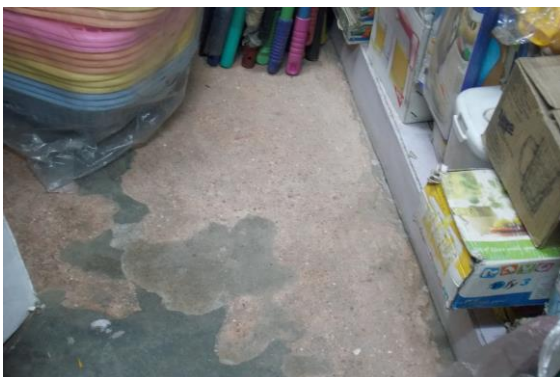
Photo 176

Peeling of Plaster on Floor of Shop No.209 of Ground Floor

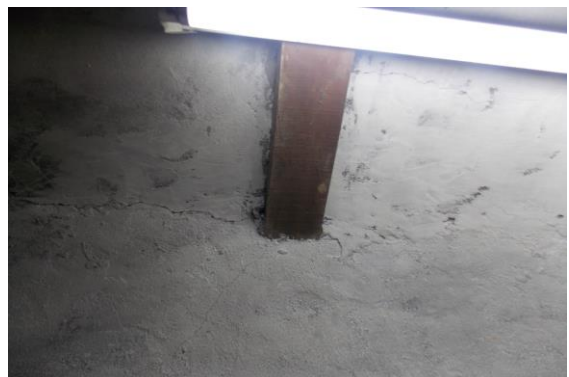
Photo 177

Peeling of Plaster on Roof of Part A of Shop No.210 of Upper Ground Floor

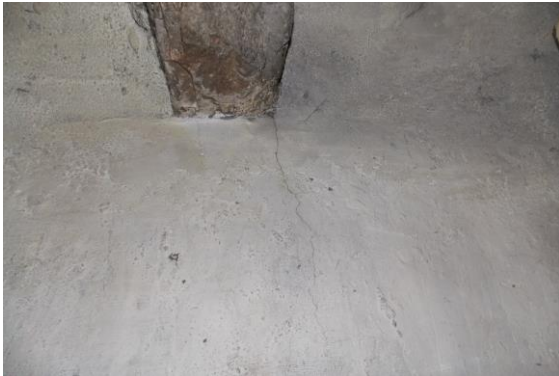
Photo 178

Peeling of Plaster on Wall No. 4 of Part A of Shop No.210 of Upper Ground Floor

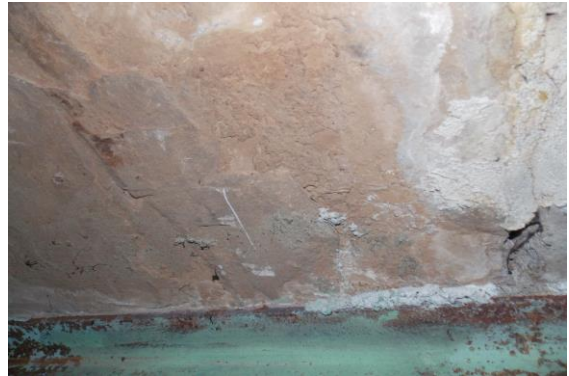
Photo 179

Peeling of Plaster on Roof of Part B of Shop No.210 of Upper Ground Floor

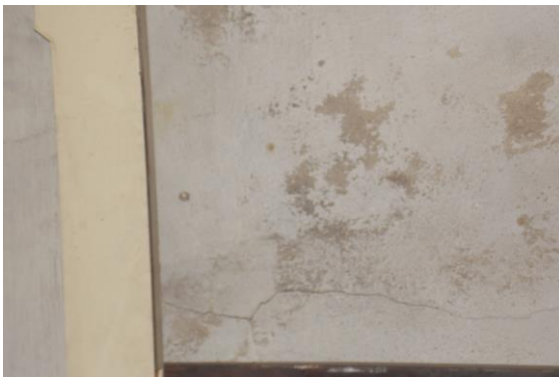
Photo 180

Peeling of Plaster on Wall No. 4 of Part B of Shop No.210 of Upper Ground Floor

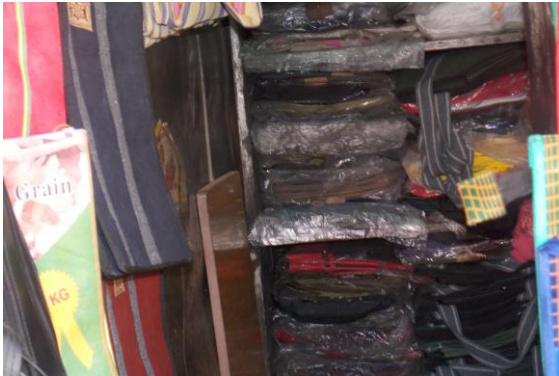
Photo 210

All Walls of Shop No. 285 B of Ground Floor Covered With Wooden Racks & Material

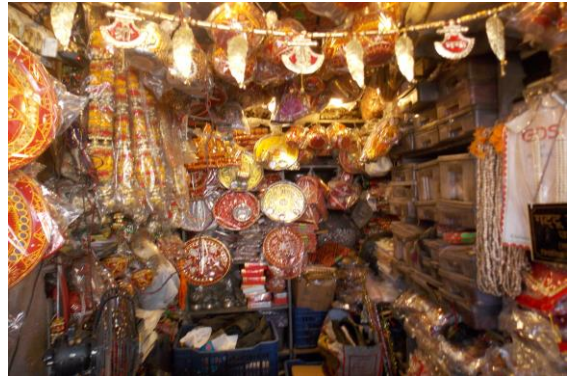
Photo 211

All Walls of Shop No. 285 A of Ground Floor Covered With Wooden Racks & Material

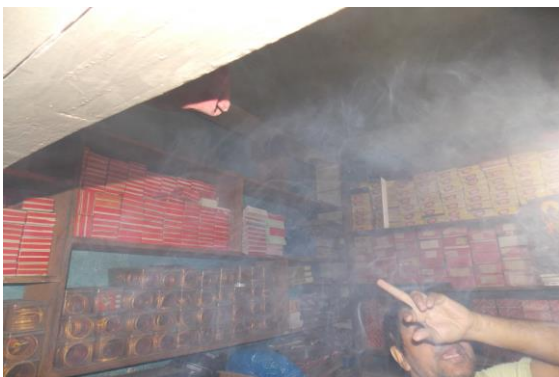
Photo 212

Wall No. 1 & 4 of Part B of Shop No. 284 of Ground Floor View of Shop

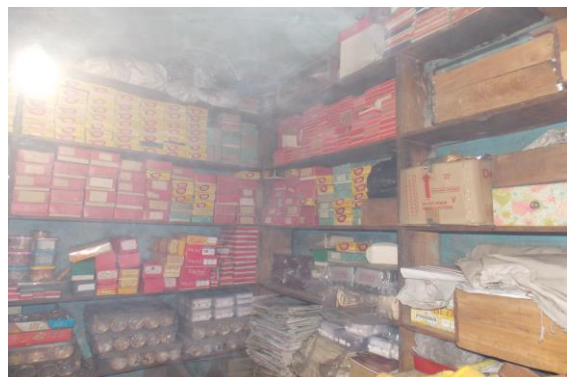
Photo 213

Wall No. 2 & 4 of Part B of Shop No. 284 of Ground Floor View of Shop

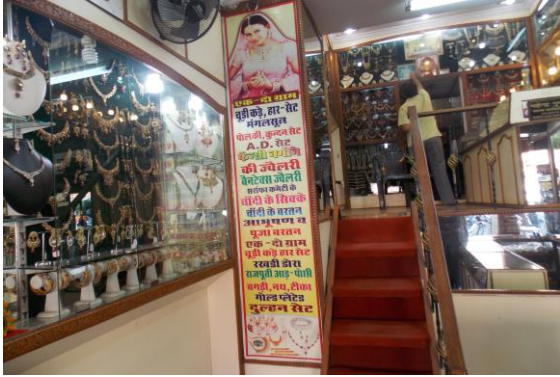
Photo 214

Wall No. 1 & 4 of Part A of Shop No.284 of Lower Portion Covered With Material

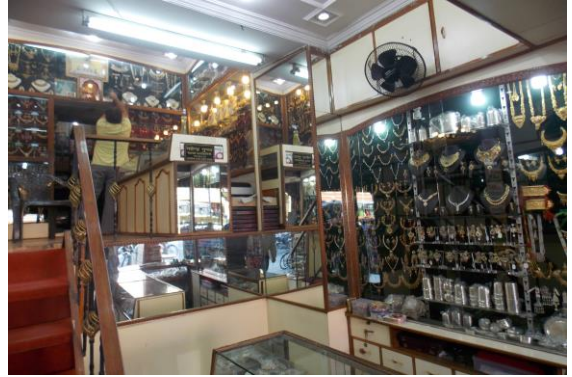
Photo 215

Wall No. 2 & 4 of Part A of Shop No.284 of Lower Portion Covered With Material

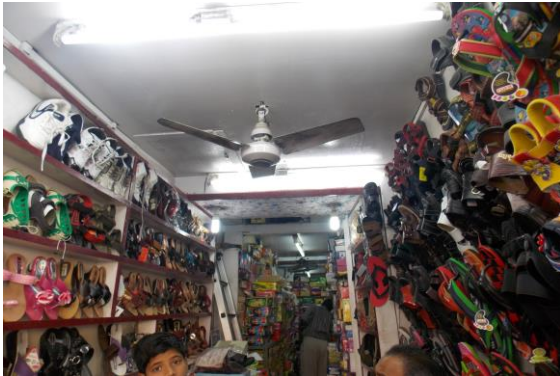
Photo 216

All Walls of Shop No.283 B of Ground Floor Covered With Wooden Racks & Material

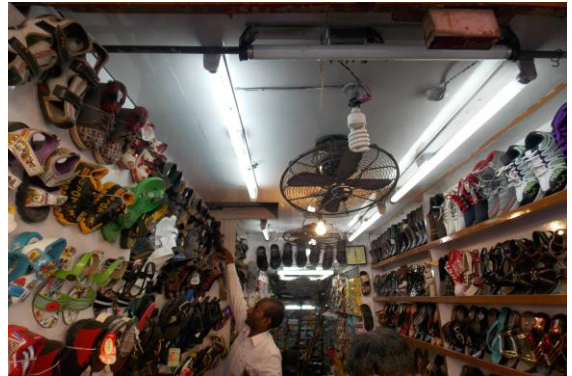
Photo 217

All Walls of Shop No.283 A of Ground Floor Covered With Wooden Racks & Material

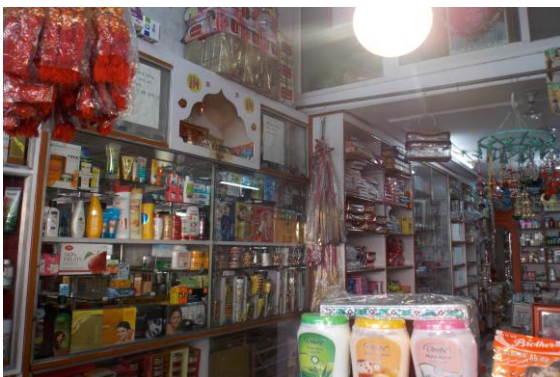
Photo 218

Wall No. 1 of Shop No.282 of Ground Floor Covered With Wooden Racks & Material

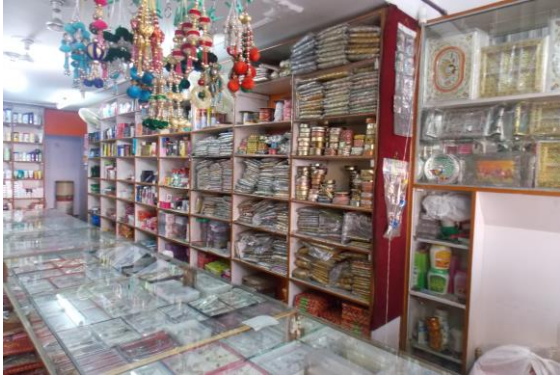
Photo 220

Wall No. 2 of Shop No.282 of Ground Floor Covered With Wooden Racks & Material

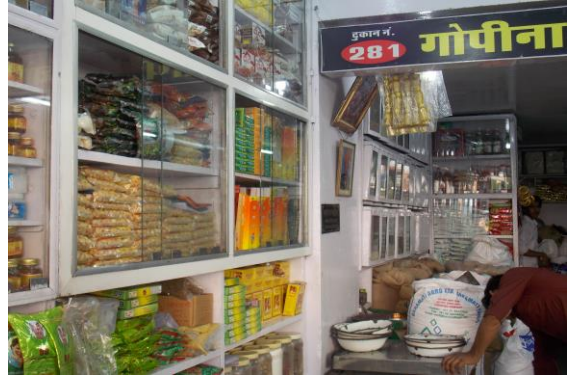
Photo 221

Wall No. 1 of Shop No.281 of Ground Floor Covered With Wooden Racks & Material

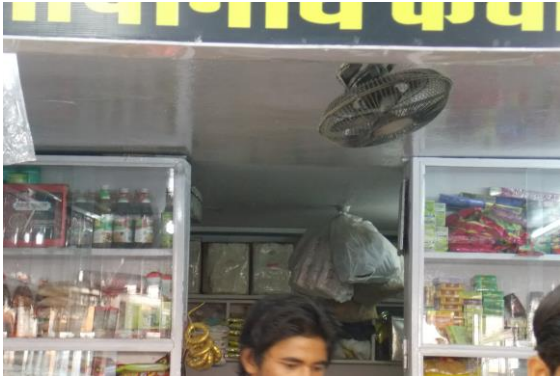
Photo 222

Wall No. 4 of Shop No.281 of Ground Floor Covered With Wooden Racks & Material

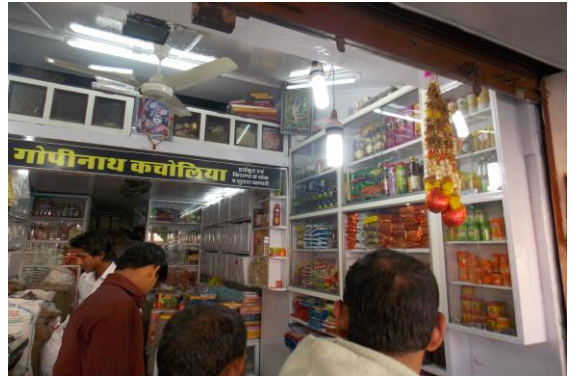
Photo 223

Wall No. 2 of Shop No.281 of Ground Floor Covered With Wooden Racks & Material

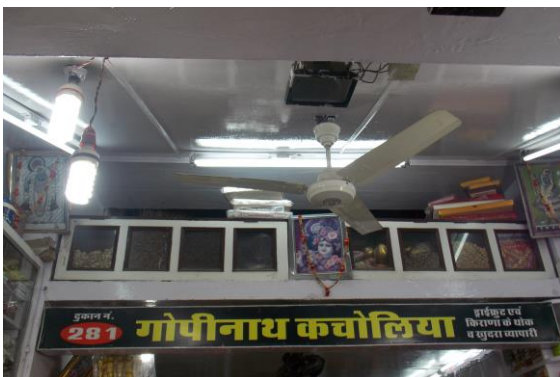
Photo 224

Roof of Shop No.281 of Ground Floor Covered With Wooden Work

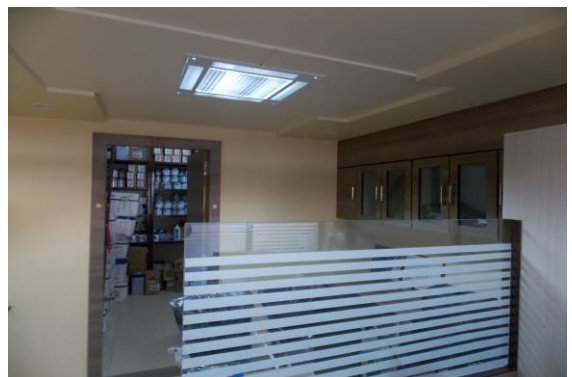
Photo 225

Wall No. 2 of Part A of Shop No.279 of Ground Floor Covered With Wooden Racks & Material

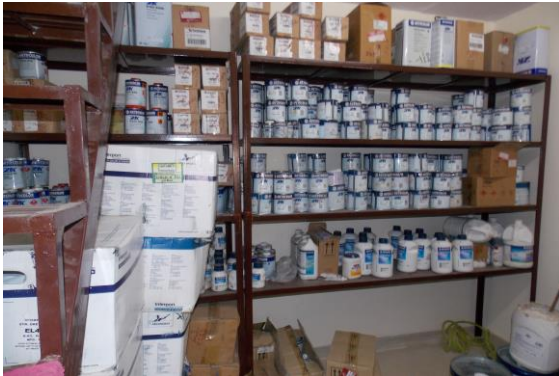
Photo 226

Wall No. 4 of Part B of Shop No.279 of Ground Floor Covered With Material

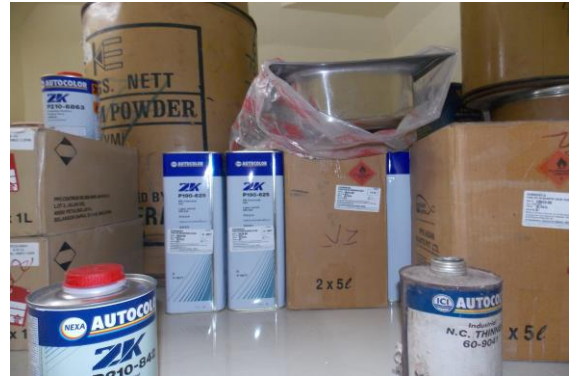
Photo 227

All Walls of Shop No.279 of Upper Ground Floor Covered With Material

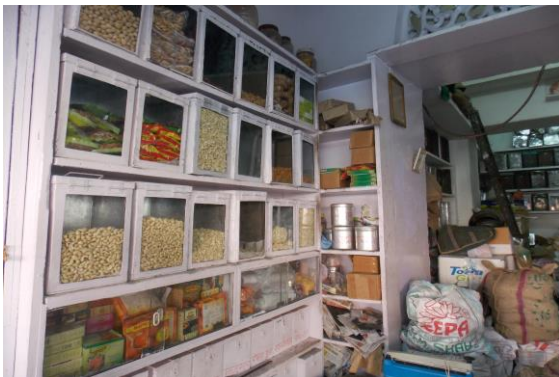
Photo 228

Wall No. 1 of Part A of Shop No.277 of Ground Floor Covered With Wooden Racks & Material

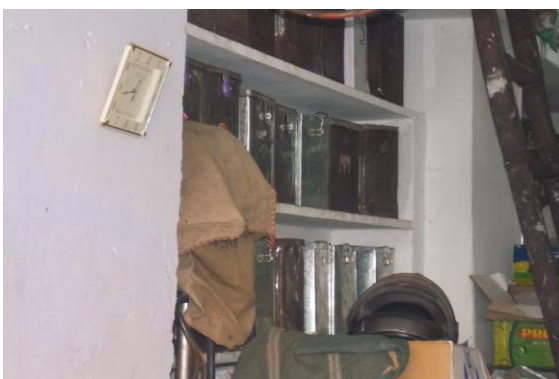
Photo 230

Wall No. 1 of Part B of Shop No.277 of Ground Floor Covered With Wooden Racks & Material

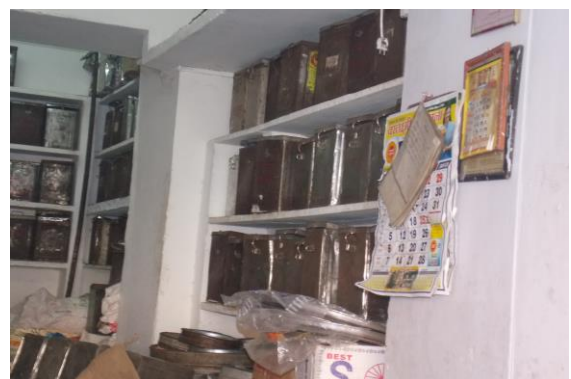
Photo 231

Wall No. 2 of Part B of Shop No.277 of Ground Floor Covered With Wooden Racks & Material

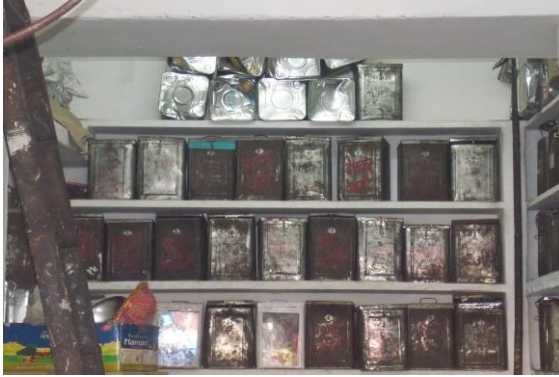
Photo 232

All Walls of Part C of Shop No.277 of Ground Floor Covered With Wooden Racks & Material

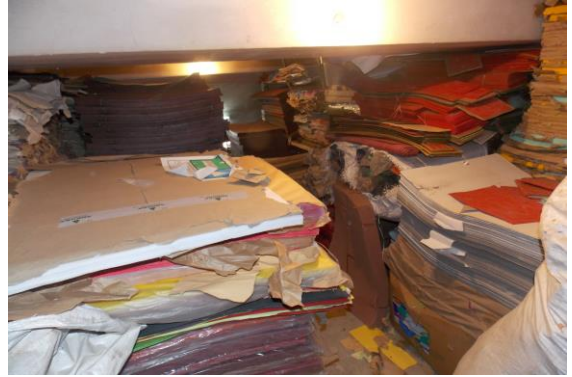
Photo 233

All Walls of Shop No.276 of Upper Ground Floor Covered With Material

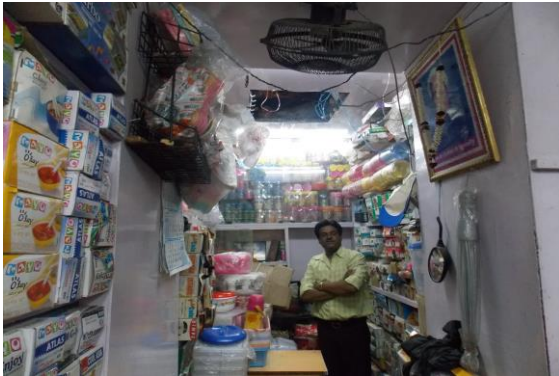
Photo 234

All Walls of Shop No.209 of Ground Floor Covered With Material

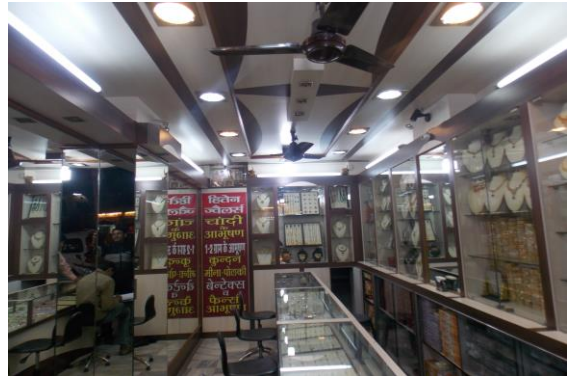
Photo 235

All Walls of Shop No.210 of Ground Floor Covered With Material

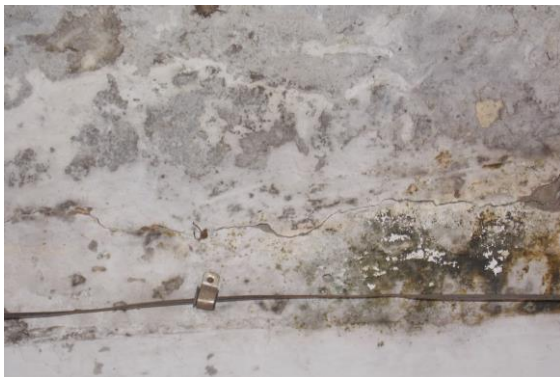
Photo 9
Horizontal Crack on Roof of Varanda of Shop No.275, Ground Floor, Approx. Width = 2mm, Approx. Length = 2.5m. Distance from Back of Right External Column = 0m, Height from Floor = 3m.

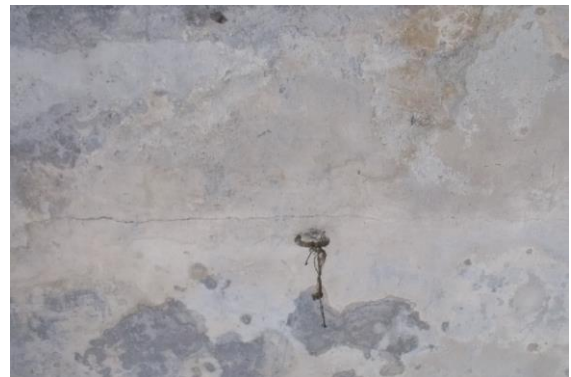
Photo 10
Horizontal Crack on Roof of Varanda of Shop No.275, Ground Floor, Approx. Width = 0.1mm, Approx. Length = 2.5m. Distance from Left External Column = 1.5m, Height from Floor = 3m.

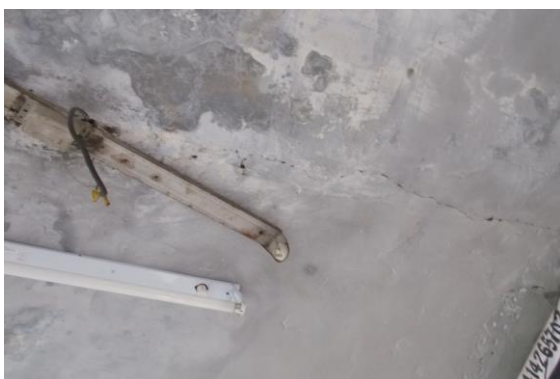
Photo 11
Horizontal Crack on Roof of Varanda of Shop No.275 A, Ground Floor, Approx. Width = 0.5mm, Approx. Length = 2.5m. Distance from Back of Left External Column = 0m, Height from Floor = 3m.

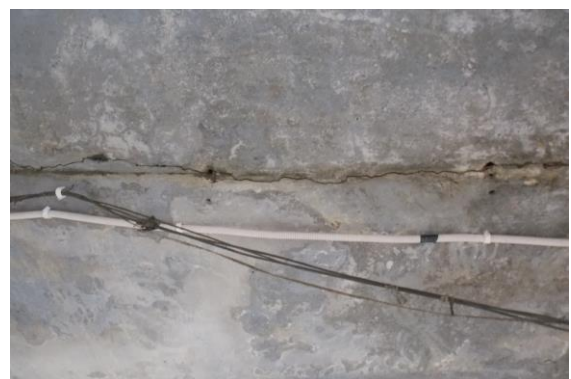
Photo 12
Horizontal Crack on Roof of Varanda of Shop No.274 A, Ground Floor, Approx. Width = 3mm, Approx. Length = 2.2m. Distance from Back of Left External Column = 0m, Height from Floor = 3m.

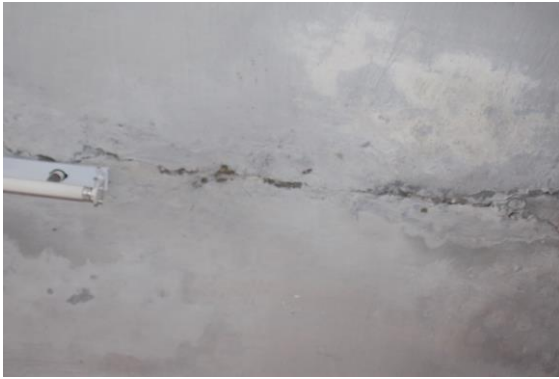
Photo 13

Horizontal Crack on Roof of Varanda of Shop No.273 A, Ground Floor, Approx. Width = 1mm, Approx. Length = 2m. Distance from Back of Left External Column = 0m, Height from Floor = 3m.

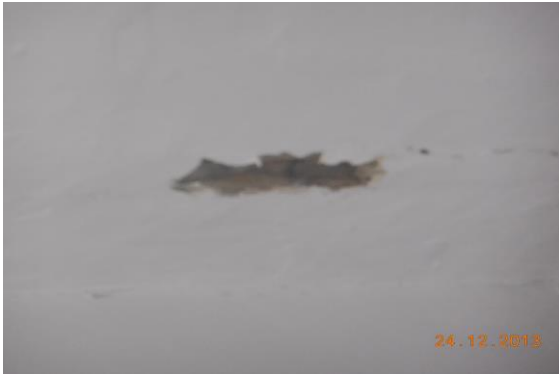
Photo 15

Horizontal Crack on Roof of Room No. 7, First Floor, Approx. Width = 0.4mm, Approx. Length = 2.5m. Distance from Wall No.2 = 1.2m, Height from Floor = 3m.

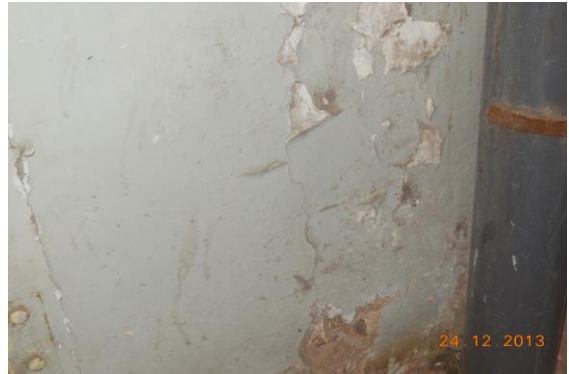
Photo 16

Vertical Crack on Wall No. 1 of Passage, First Floor, Approx. Width = 0.25mm, Approx. Length = 1.7m. Distance from Wall No.1 = 5m, Height from Floor = 1.3m.

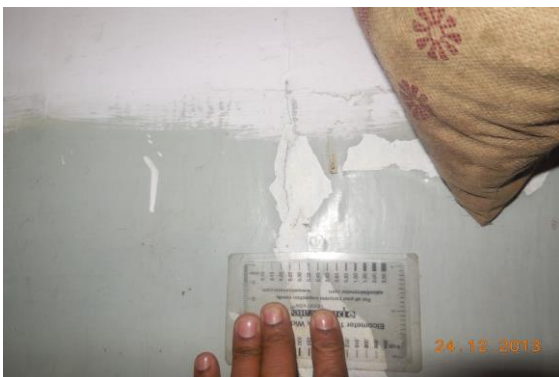
Photo 16A

Vertical Crack on Wall No. 1 of Passage, First Floor, Approx. Width = 0.25mm, Approx. Length = 1.7m. Distance from Wall No.1 = 5m, Height from Floor = 1.3m.

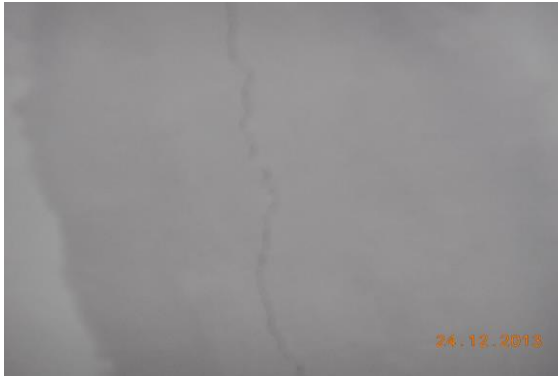
Photo 17

Horizontal Crack on Roof of Hall No. 1, Second Floor, Approx. Width = 0.4mm, Approx. Length = 4m. Distance from Wall no.1 = 2.5m, Height from Floor = 3m.

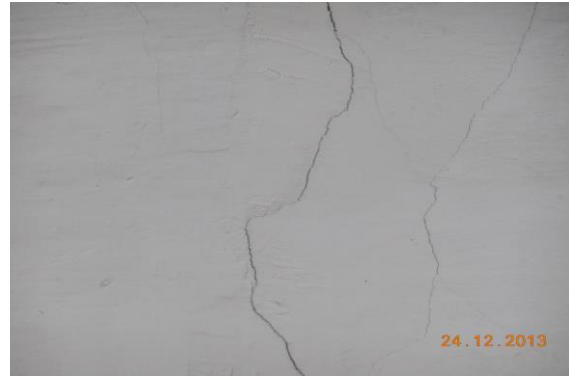
Photo 18

Inclined Crack on Wall No. 2 of Hall No. 1, Second Floor, Approx. Width = 0.3mm, Approx. Length = 3.5m. Distance from Wall No.3 = 1.8m, Height from Floor = 1.3m.

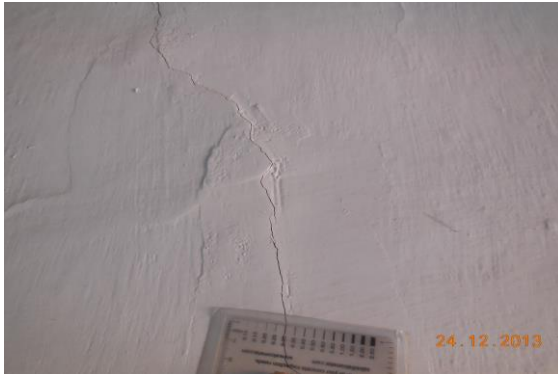
Photo 18A

Inclined Crack on Wall No. 2 of Hall No. 1, Second Floor, Approx. Width = 0.3mm, Approx. Length = 3.5m. Distance from Wall No.3 = 1.8m, Height from Floor = 1.3m.

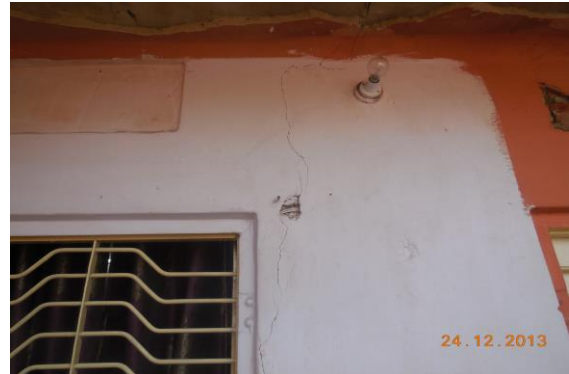
Photo 19

Vertical Crack on Wall No. 4 of Staircase Area, Second Floor, Approx. Width = 0.5mm, Approx. Length = 1.5m. Distance from Wall no.2 = 1.8m, Height from Floor = 2.2m.

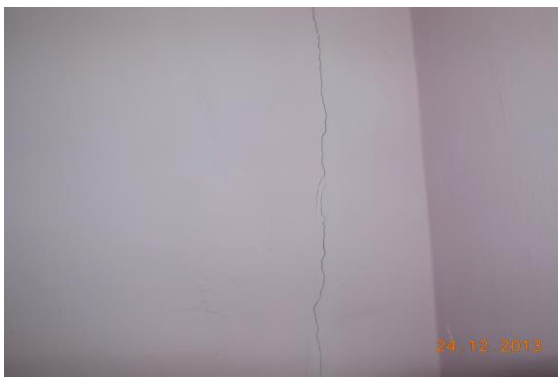
Photo 20

Vertical Crack on Wall No. 1 of Hall No. 1, Second Floor, Approx. Width = 0.4mm, Approx. Length = 2.7m. Distance from Wall No.4 = 0.2m, Height from Floor = 0.3m.

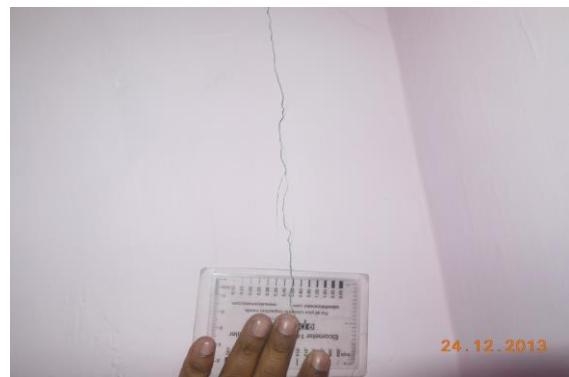
Photo 20A

Vertical Crack on Wall No. 1 of Hall No. 1, Second Floor, Approx. Width = 0.4mm, Approx. Length = 2.7m. Distance from Wall No.4 = 0.2m, Height from Floor = 0.3m.

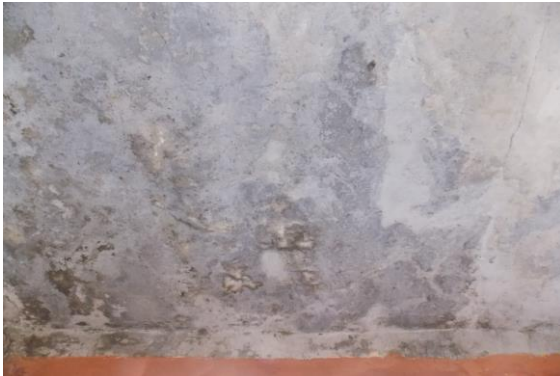
Photo 21

Dampness/Seepage on Roof of Varanda of Shop No.275 of Ground Floor

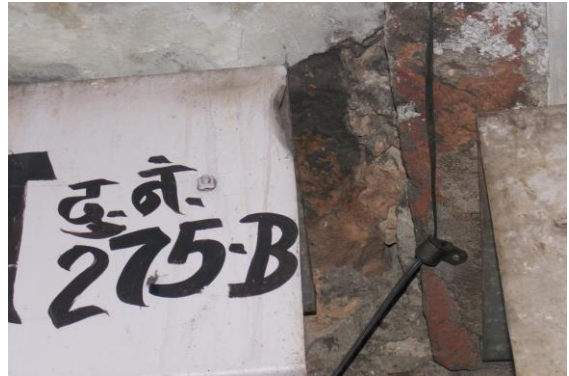
Photo 22

Damaged Portion on Roof of Varanda of Shop No.275 of Ground Floor

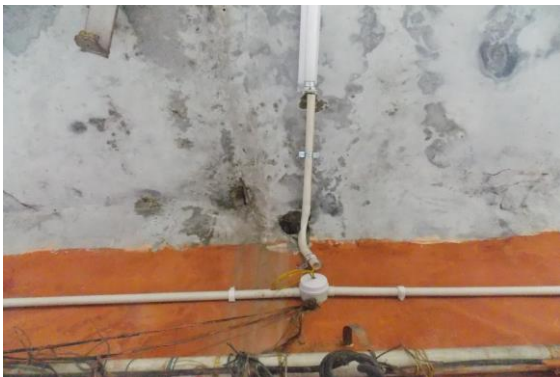
Photo 23

Peeling of Plaster on Roof of Varanda of Shop No.275 A of Ground Floor

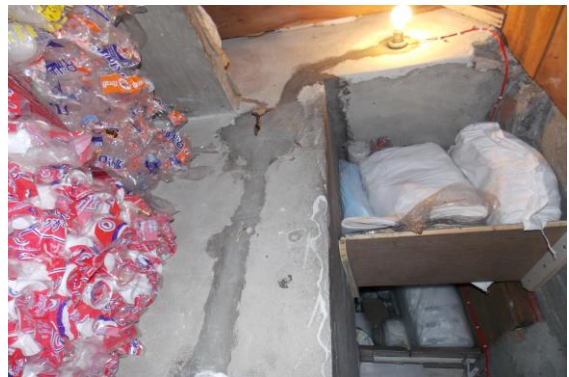
Photo 24

Peeling of Plaster on Wall No. 3 of Part B of Shop No.274 B of Ground Floor

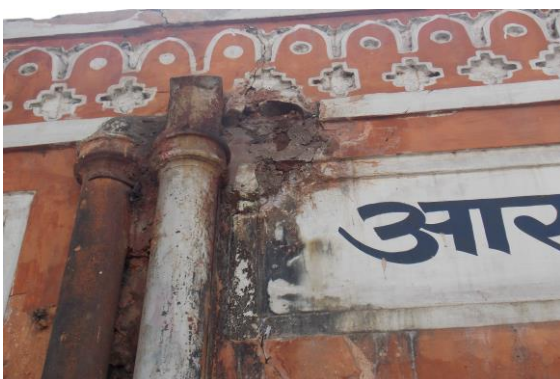
Photo 25

Damaged Portion on Left side External Column of Varanda of Shop No.274 A of Ground Floor

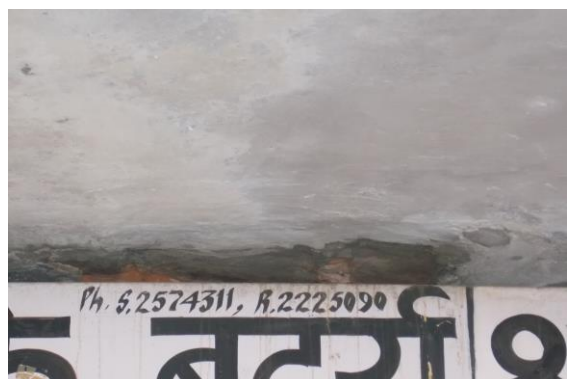
Photo 26

Dampness/Seepage on Roof of Varanda of Shop No.274 A of Ground Floor

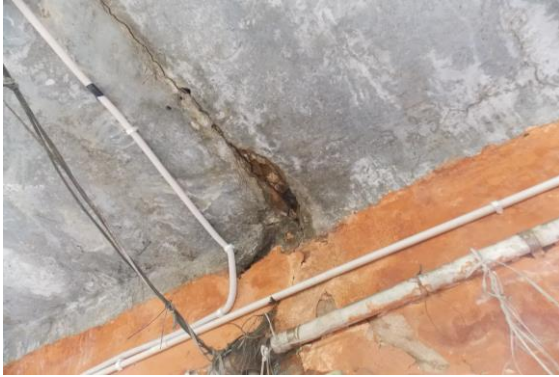
Photo 27

Damaged Portion on Roof of Varanda of Shop No.274 A of Ground Floor

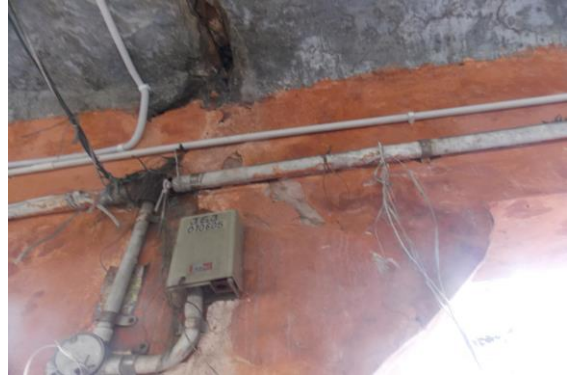
Photo 28

Peeling of Plaster on Left side External Column of Varanda of Shop No.274 A of Ground Floor

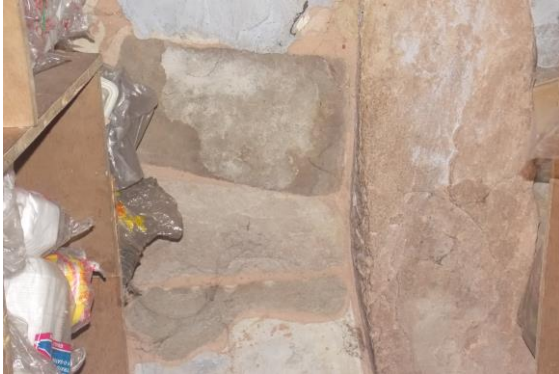
Photo 29

Peeling of Plaster on Roof of Part B of Shop No.273 B of Ground Floor

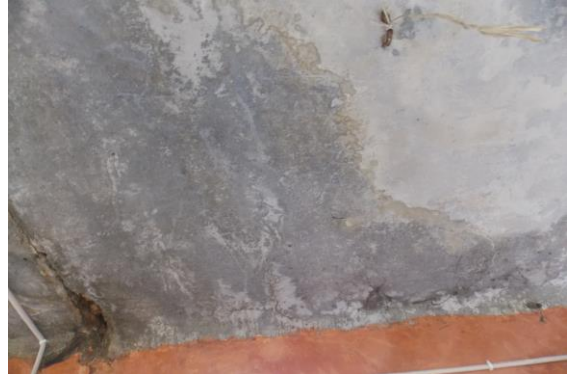
Photo 30

Dampness/Seepage on Roof of Varanda of Shop No.273 B of Ground Floor

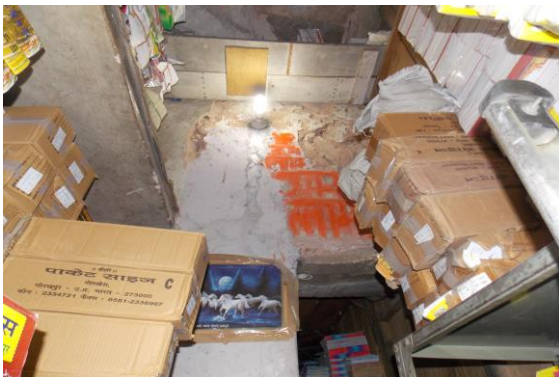
Photo 31

Damaged Portion on Wall No. 4 of Part B of Shop No.273 A of Ground Floor

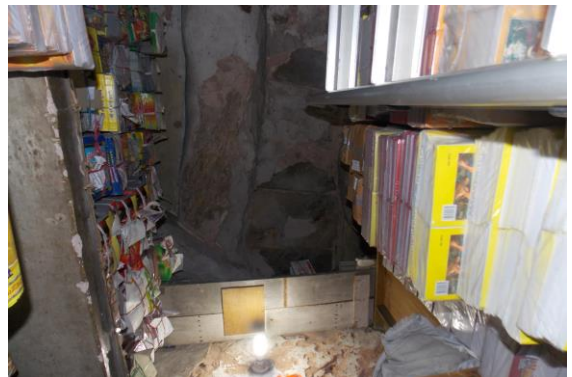
Photo 32

Damaged Portion on Roof of Part B of Shop No.273 A of Ground Floor

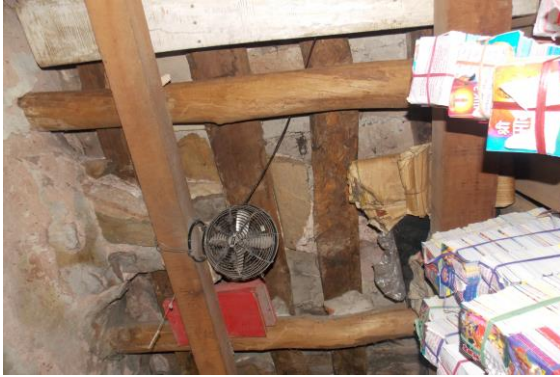
Photo 33

Damaged Portion on Roof of Part C of Shop No.273 A of Ground Floor

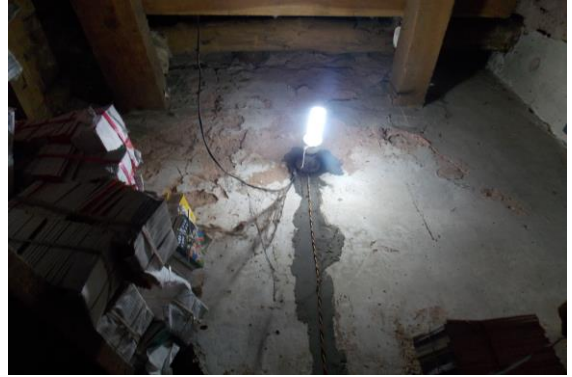
Photo 34

Peeling of Plaster on Wall No. 3 of Part C of Shop No.273 A of Ground Floor

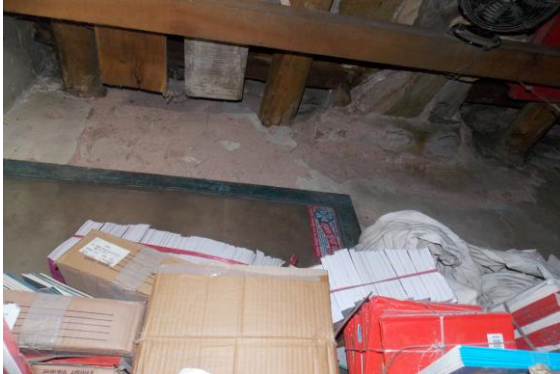
Photo 35

Peeling of Plaster on Wall No. 1 of Part C of Shop No.273 A of Ground Floor

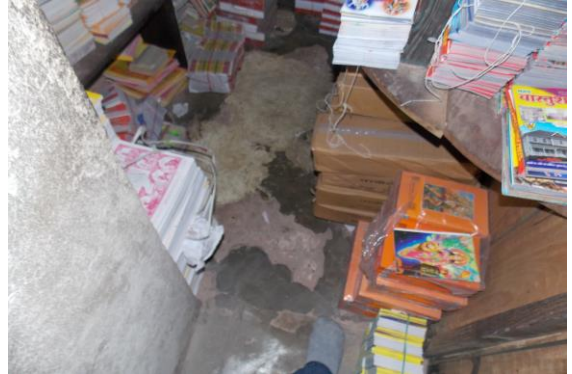
Photo 36

Damaged Portion on Floor of Part C of Shop No.273 A of Ground Floor

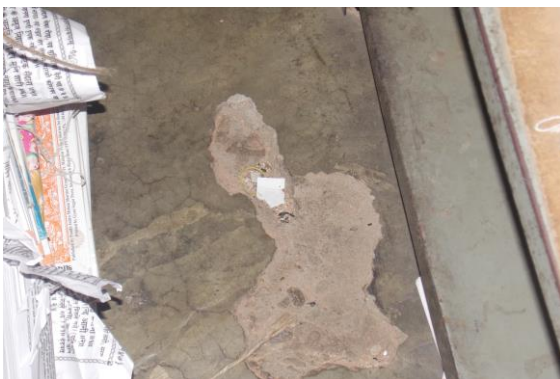
Photo 37

Damaged Portion on Floor of Part B of Shop No.273 A of Ground Floor

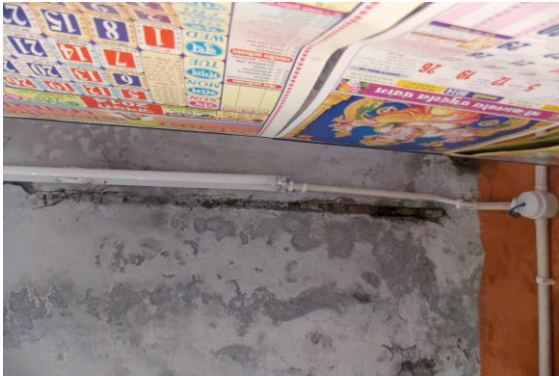
Photo 39

Damaged Portion on Roof of Varanda of Shop No.273 A of Ground Floor

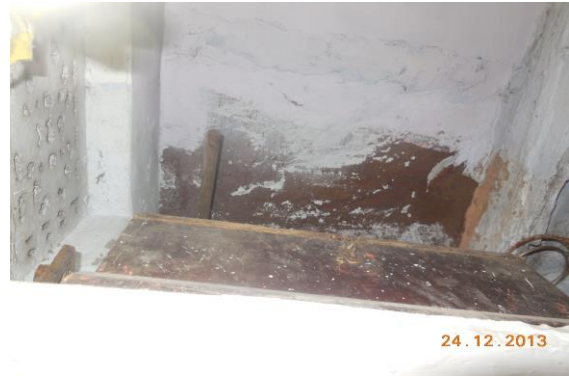
Photo 40

Peeling of Plaster on Roof of Temple of First Floor

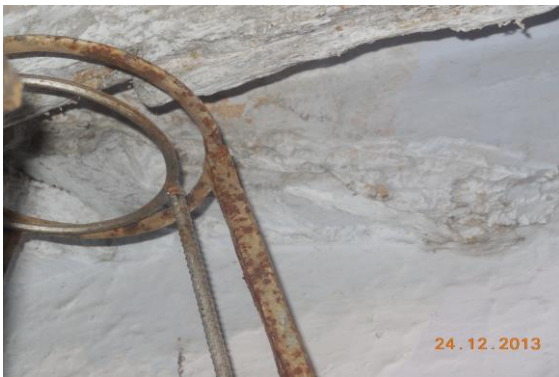
Photo 41

Damaged Portion on Wall No. 4 of Temple of First Floor

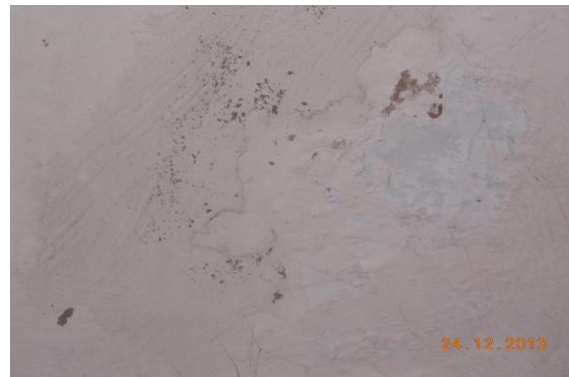
Photo 42

Peeling of Plaster on of Room No. 1 of First Floor

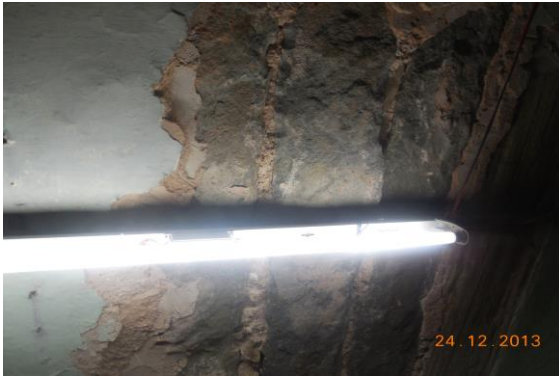
Photo 45

Peeling of Plaster on Wall No. 4 of Room No. 5 of First Floor

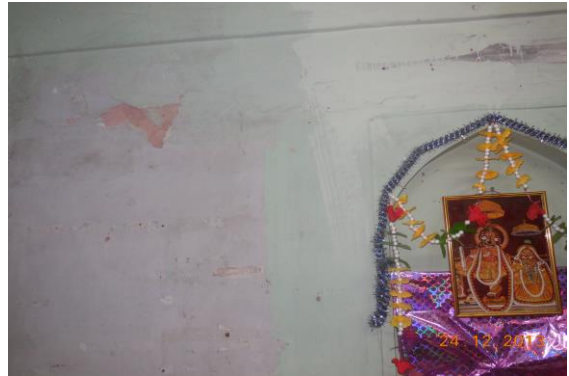
Photo 46

Peeling of Plaster on Wall No. 1 of Room No. 5 of First Floor

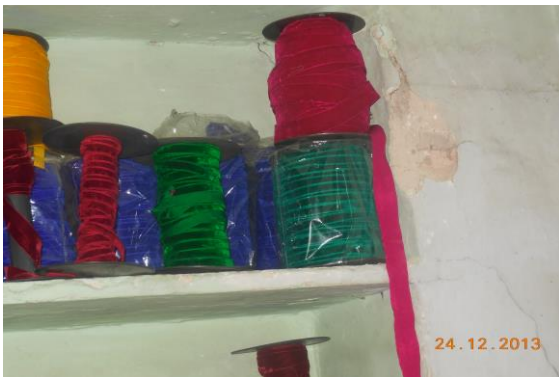
Photo 47

Peeling of Plaster on Wall No. 3 of Room No. 5 of First Floor

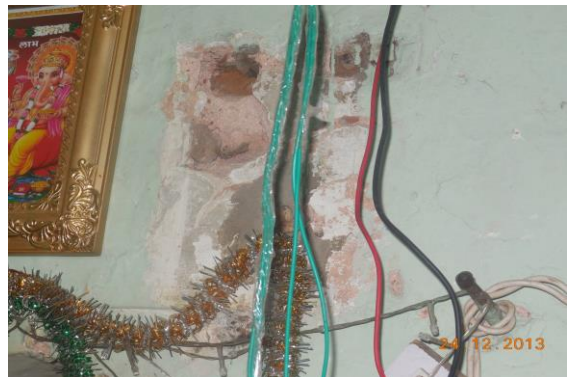
Photo 48

Peeling of Plaster on Wall No. 2 of Room No. 5 of First Floor

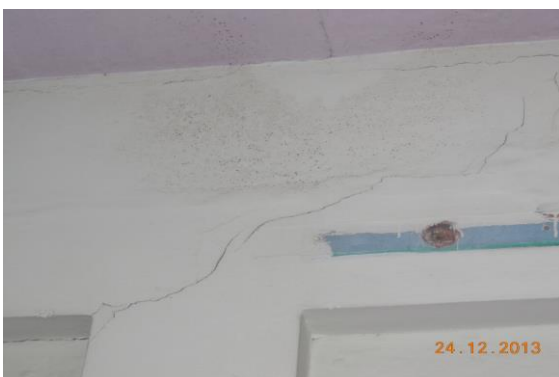
Photo 49

Dampness/Seepage on Wall No. 2 & 3 of Room No. 6 of First Floor

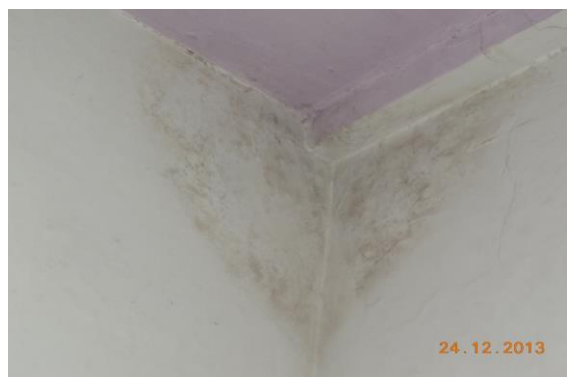
Photo 50

Peeling of Plaster on Roof of Room No. 7 of First Floor

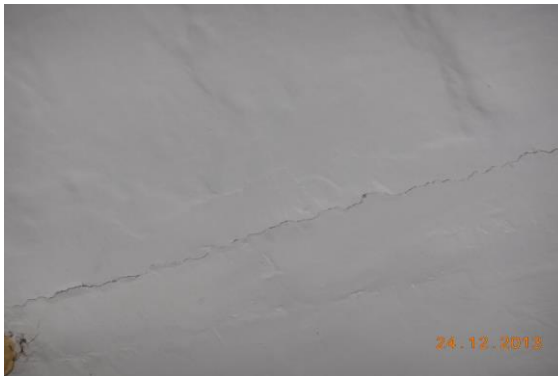
Photo 51
Peeling of Plaster on Wall No. 2 of Room No. 7 of First Floor

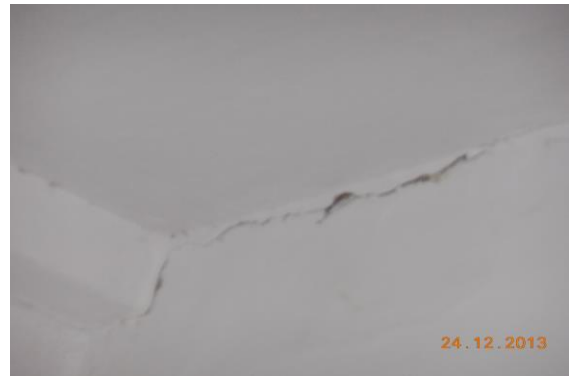
Photo 52
Dampness/Seepage on Roof of Hall No. 1 of First Floor

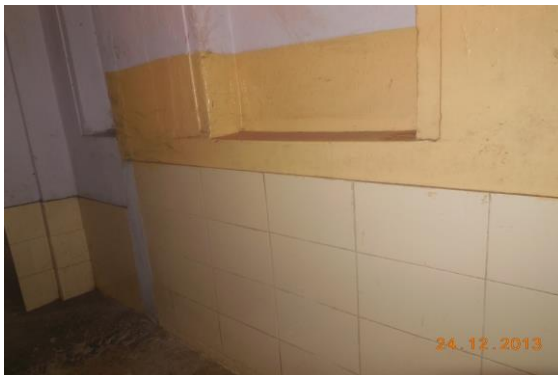
Photo 53
Dampness/Seepage on Roof of Passage of First Floor

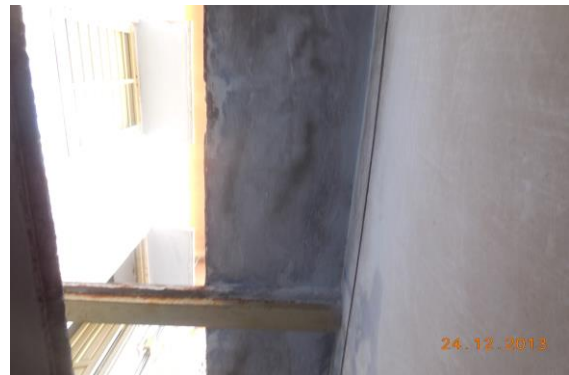
Photo 54
Dampness/Seepage on Wall No. 2 of Passage of First Floor

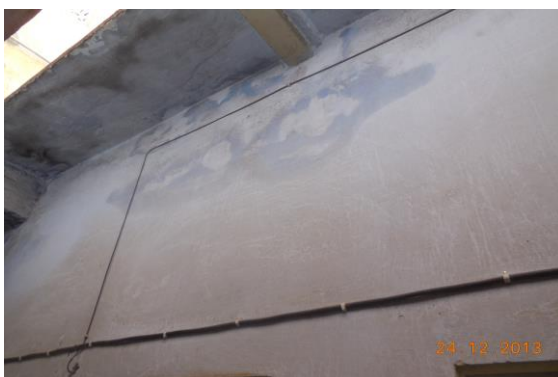
Photo 55
Damaged Portion on Roof of Passage of First Floor

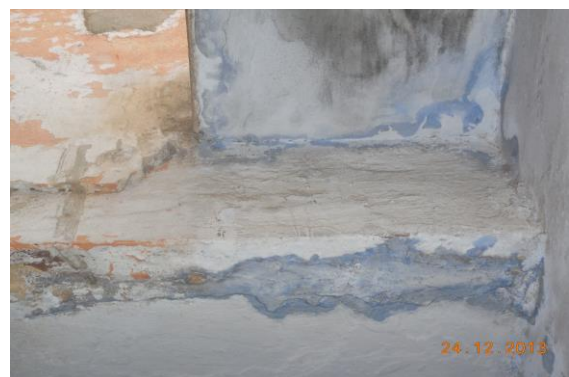
Photo 56
Peeling of Plaster on Wall No. 1 of Passage of First Floor

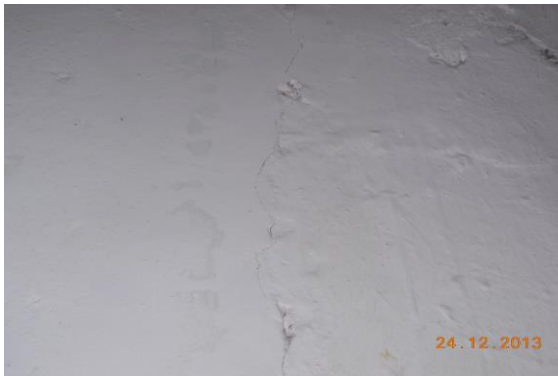
Photo 57

Damaged Portion on Wall No. 1 of House No.843,844 of First Floor

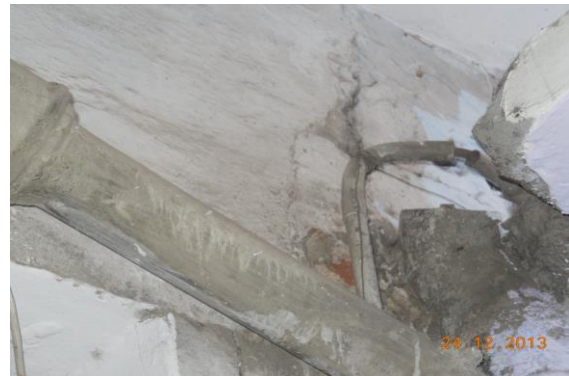
Photo 58

Peeling of Plaster on Wall No. 1 of Staircase No.2 of First Floor

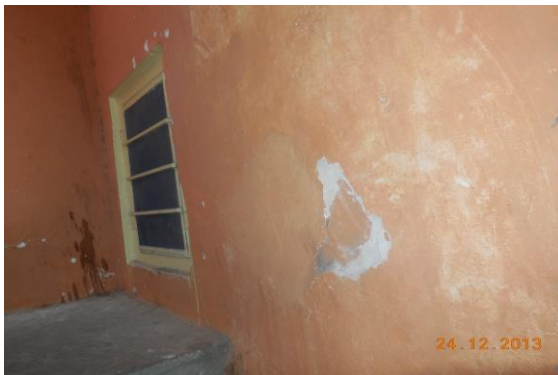
Photo 59

Peeling of Plaster on Wall No. 2 of Staircase No.2 of First Floor

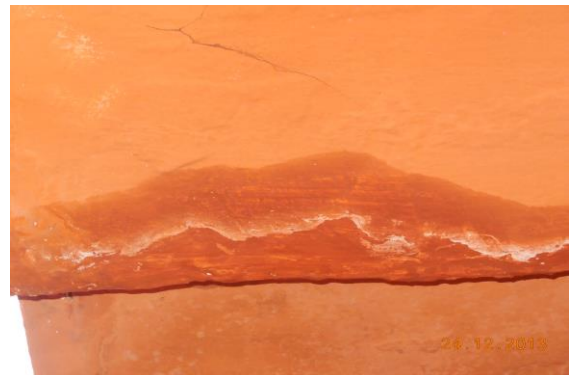
Photo 60

Dampness/Seepage on Roof of Staircase No.2 of First Floor

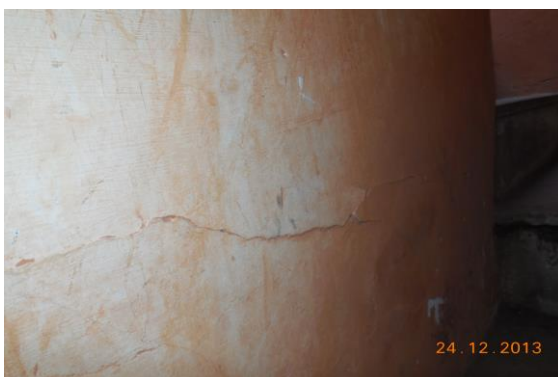
Photo 61

Peeling of Plaster on Wall No. 1 of Staircase No.2 of First Floor

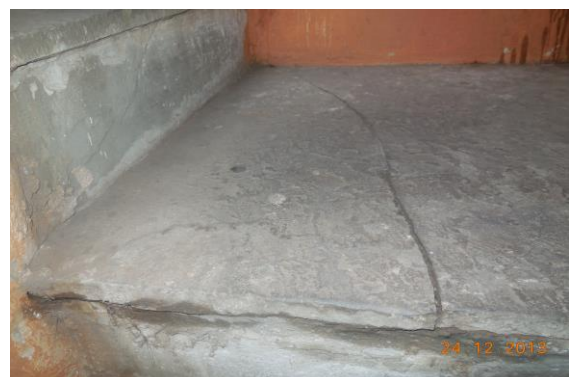
Photo 62

Damaged Portion on Steps of Staircase No.2 of First Floor

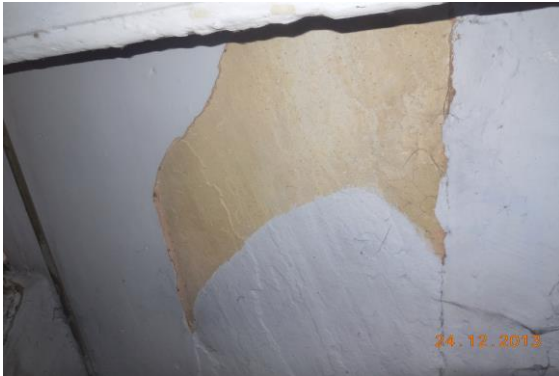
Photo 63
Peeling of Plaster on Roof of Passage of First Floor

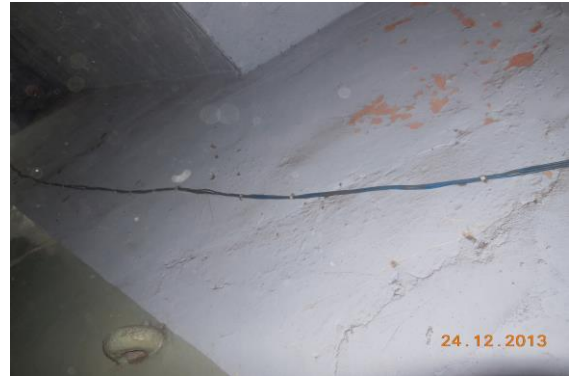
Photo 64
Peeling of Plaster on Wall No. 1 of Staircase No.1 of First Floor

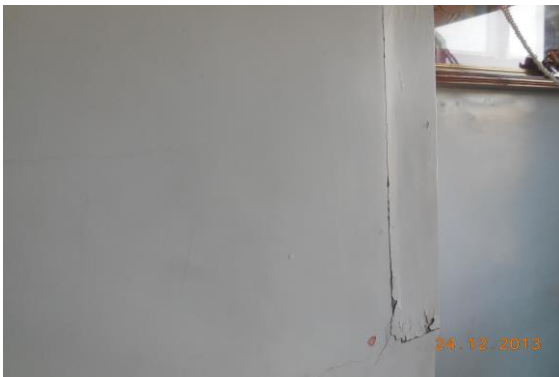
Photo 65
Peeling of Plaster of Room No. 1 of Second Floor

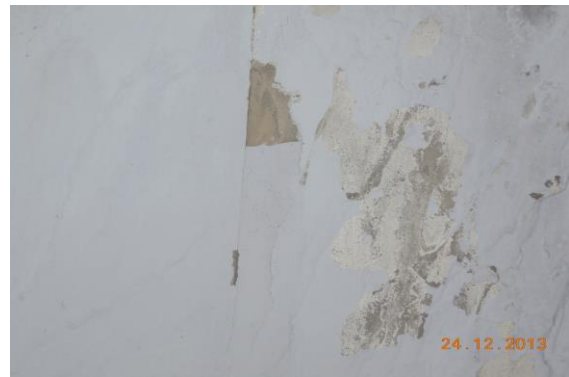
Photo 66
Peeling of Plaster on Roof of Lobby of House No.843,844 of Second Floor

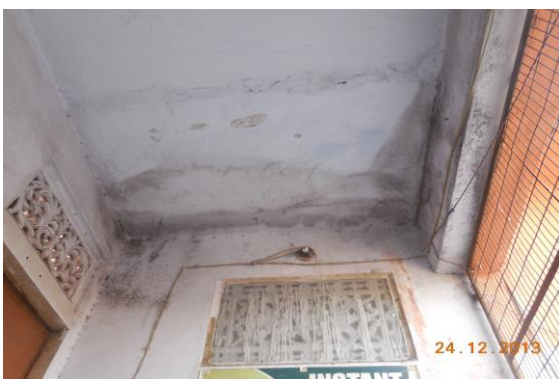
Photo 67
Dampness/Seepage on Roof of Lobby of House No.843,844 of Second Floor

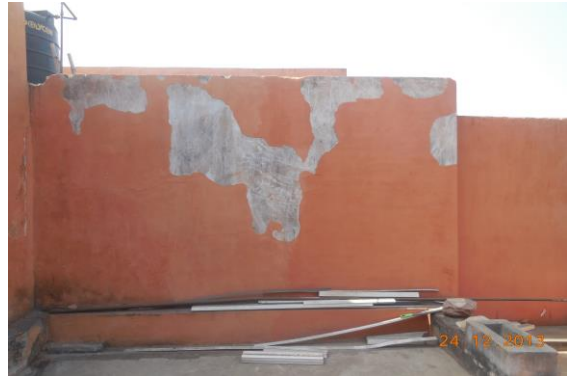
Photo 70
Peeling of Plaster on Wall No. 4 of Open Area of Second Floor

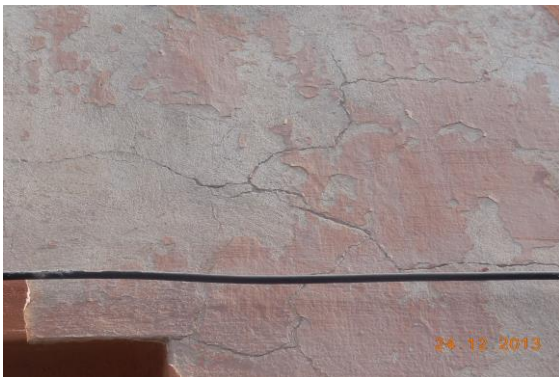
Photo 71
Peeling of Plaster on Wall No. 3 of Open Area of Second Floor

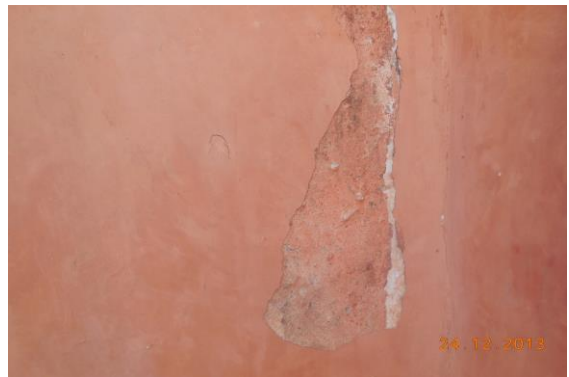
Photo 72
Peeling of Plaster on Outer wall of Toilet No. 2 of Second Floor

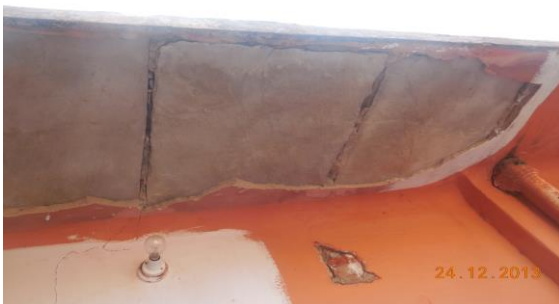
Photo 73
Damaged Portion on Shade of Hall No. 2 of Second Floor

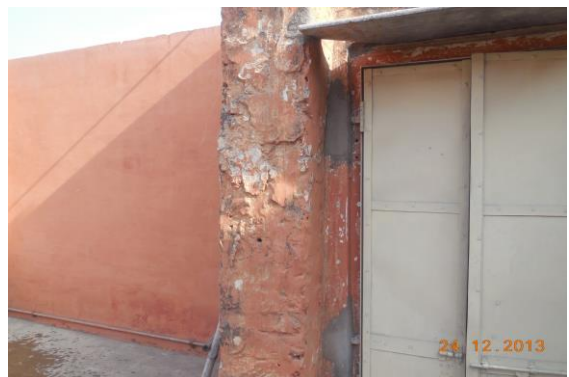
Photo 74
Peeling of Plaster of External Façade of House No.843,844 of Second Floor

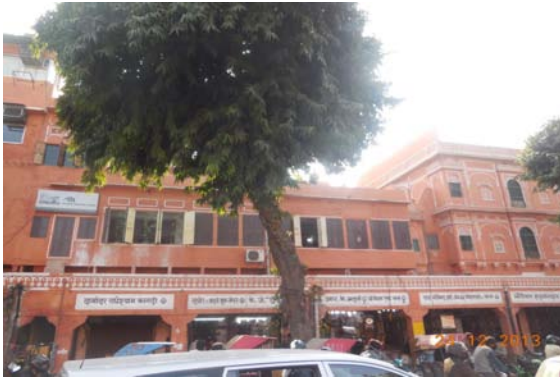
Photo 75

Damaged Portion of External Façade of House No.843,844 of Second Floor

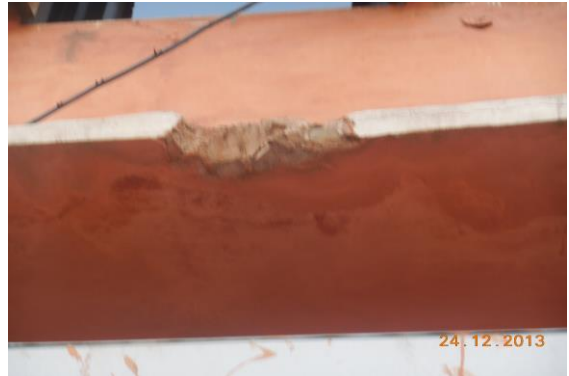
Photo 76

Peeling of Plaster on Roof Shade & Front side of House No.843,844 of Second Floor
