Pre Building Condition Survey Report

Name and Address of Structure :	Choti Chopar to Badi Chopar (Down Line)
---------------------------------	---

Name of the Project	Contract JMRC-UG1B “Design and Construction of Tunnel between Chandpole and Badi Chouper and reverse line by Shield TBM, Underground Metro Stations at Choti Chouper and Badi Chouper by Cut and Cover Methods on East West Corridor of Jaipur Metro Rail Corporation Limited .”	
Owner :

Pre Building Condition Survey Report Choti Chopar to Badi Chopar (Down Line)

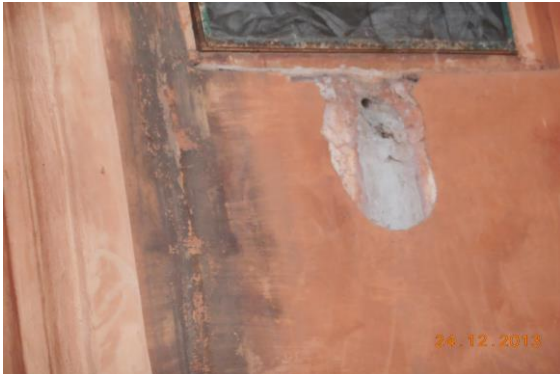
Photo 77

Peeling of Plaster on Front side Wall of External Façade of House No.843-844, Second Floor

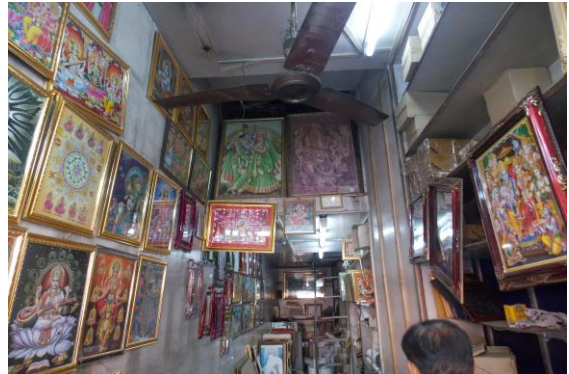
Photo 78

All Walls of Shop No.275 of Ground Floor Covered With Wooden Rack & Material

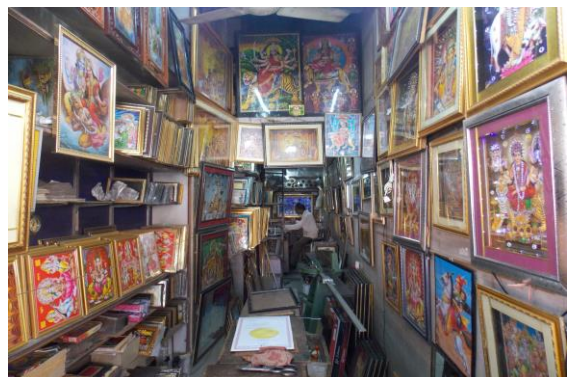
Photo 80

All Walls of Shop No.275 A of Ground Floor Covered With Wooden Rack & Material

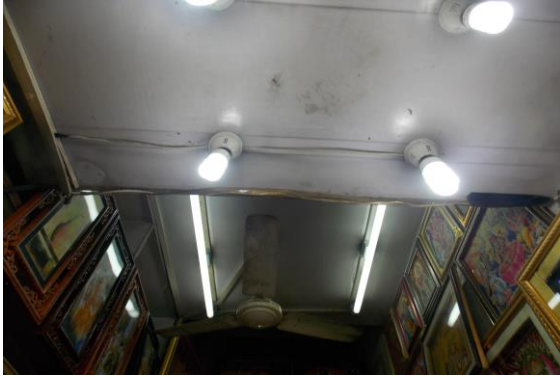
Photo 81

Roof of Shop No. 275 A of Ground Floor Covered With Wooden Work

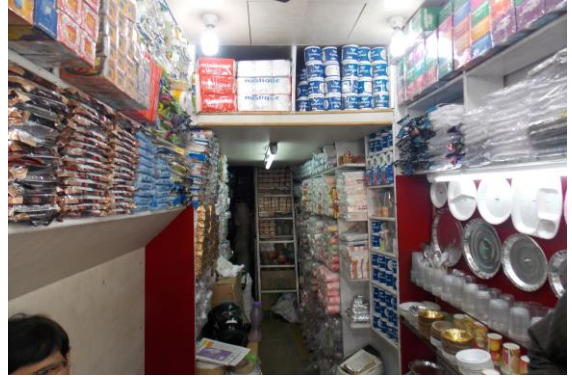
Photo 82

Wall No. 1, 2, 4 & B of Part A of Shop No. 274 B of Ground Floor Covered With Wooden Racks & Material

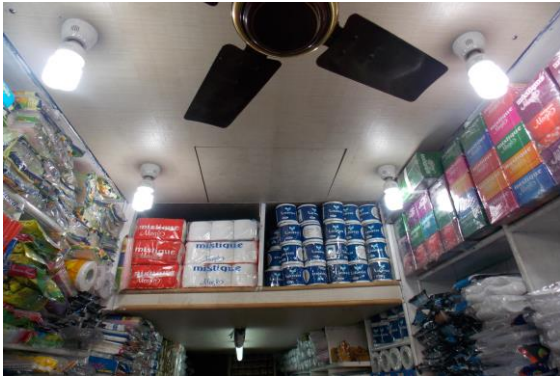
Photo 83

Roof of Part A of Shop No. 274 B of Ground Floor Covered With Wooden Work

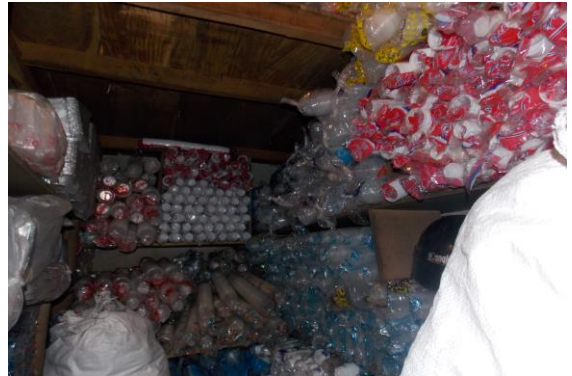
Photo 84

Wall No. 2 & 4 of Part B of Shop No. 274 B of Ground Floor Covered With Material

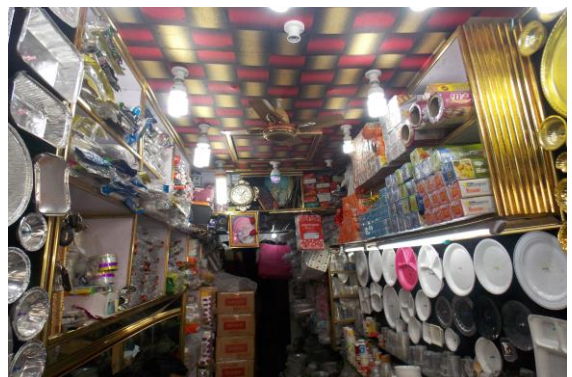
Photo 86

All Walls & Roof of Shop No. 274 A of Ground Floor Covered With Wooden Work & Material

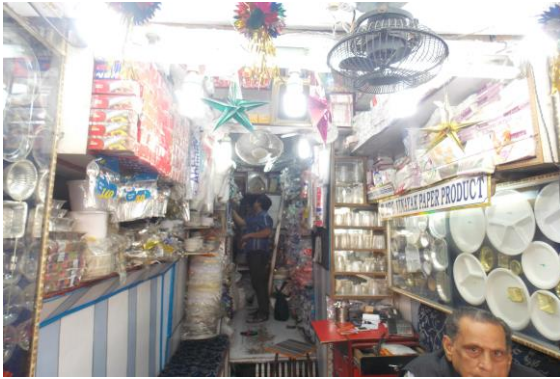
Photo 87

All Walls of Part A of Shop No.273 B of Ground Floor Covered With Wooden Work & Material

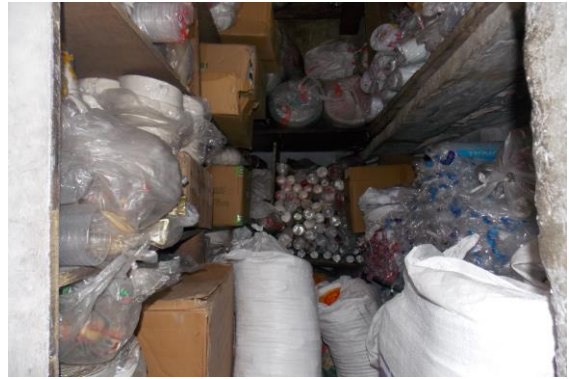
Photo 88

All Walls of Part C of Shop No.273 B of Upper Ground Floor Covered With Wooden Work & Material

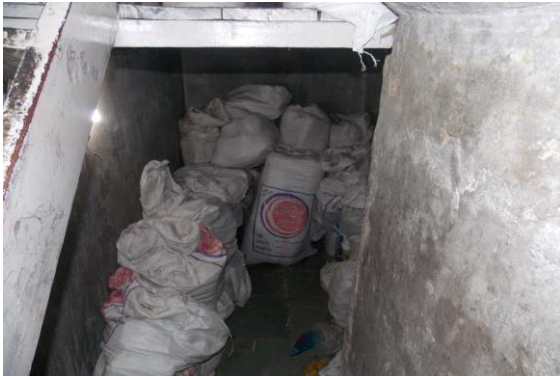
Photo 89

All Walls of Part C of Shop No.273 B of Lower Ground Floor Covered With Wooden Work & Material

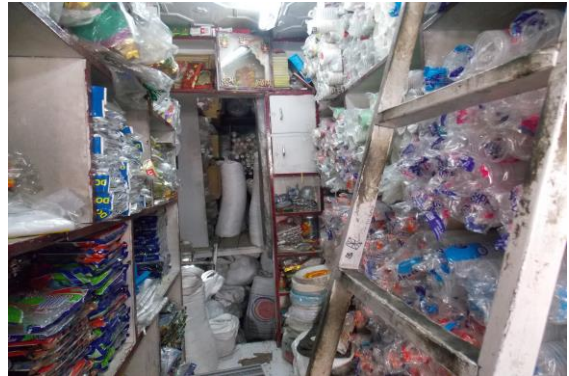
Photo 90

All Walls of Part C of Shop No.273 B of Ground Floor Covered With Wooden Work & Material

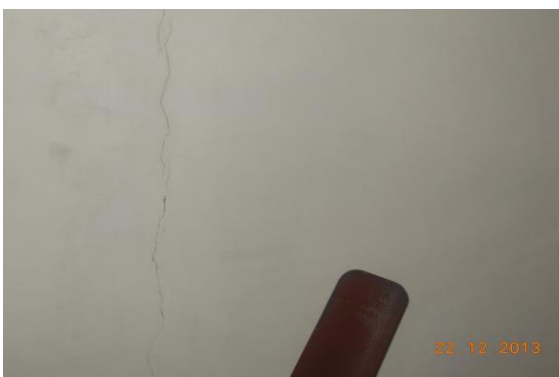
Photo 5
Horizontal Crack on Wall No. 1 & Roof of Room No. 1, House Above Shop No.270 & 271, First Floor Approx. Width = 0.35mm, Approx. Length = 2.9m. Distance from Wall No.1 = 1.6m, Height from Floor = 3m

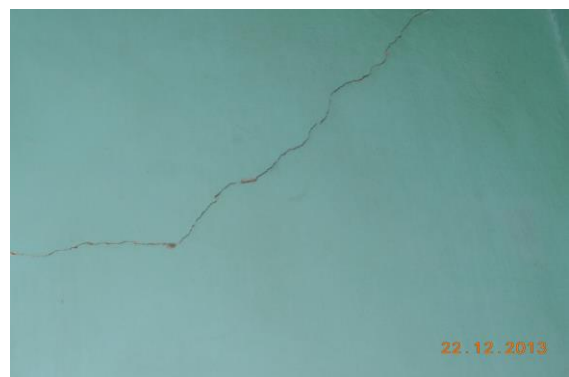
Photo 6
Inclined Crack on Wall No. 4 of Kitchen, House Above Shop No.270 & 271, First Floor Approx. Width = 1.5mm, Approx. Length = 1.2m. Distance from = m, Height from Floor = 2.5m.

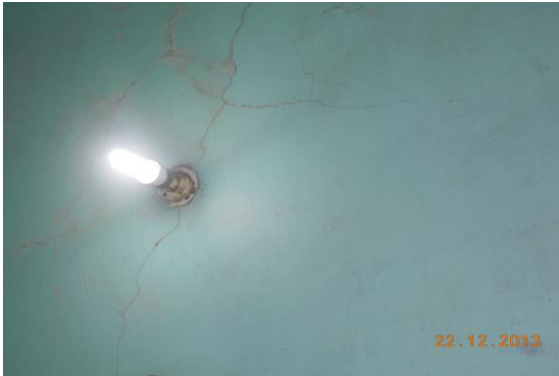
Photo 7

Inclined Crack on Wall No. 4 of Kitchen, House Above Shop No.270 & 271, First Floor Approx. Width = 1mm, Approx. Length = 2m. Distance from = m, Height from Floor = 2m.

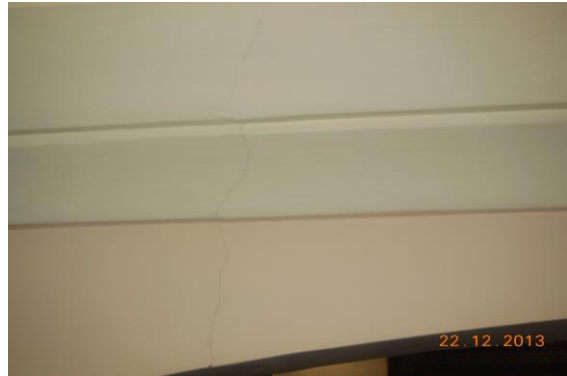
Photo 8

Horizontal Crack on Roof of Hall No. 1, House Above Shop No.270 & 271, First Floor Approx. Width = 0.4mm, Approx. Length = 2.5m. Distance from Wall No.4 = 3m, Height from Floor = 1.7m.

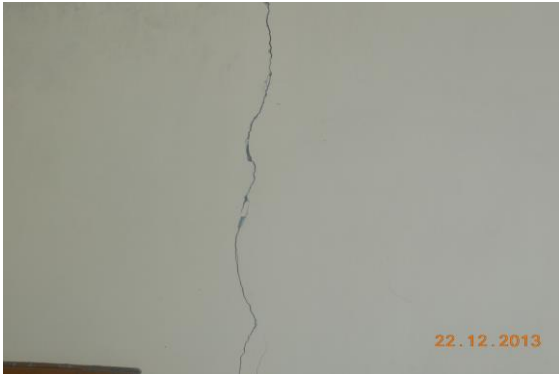
Photo 9

Vertical Crack on Wall No. 4 of Lobby No.2, House Above Shop No.270 & 271, First Floor Approx. Width = 2.5mm, Approx. Length = 3m. Distance from Wall No.2 = 1.5m, Height from Floor = 0.1m.

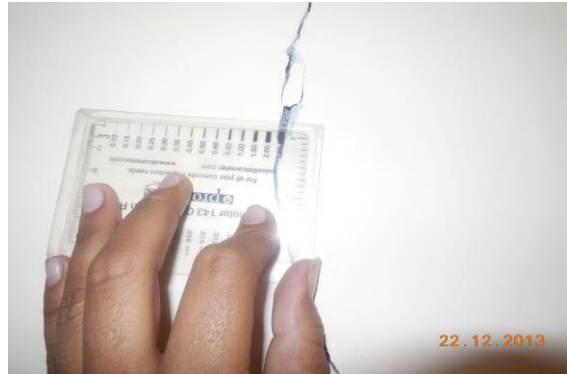
Photo 9A

Vertical Crack on Wall No. 4 of Lobby No.2, House Above Shop No.270 & 271, First Floor Approx. Width = 2.5mm, Approx. Length = 3m. Distance from Wall No.2 = 1.5m, Height from Floor = 0.1m.

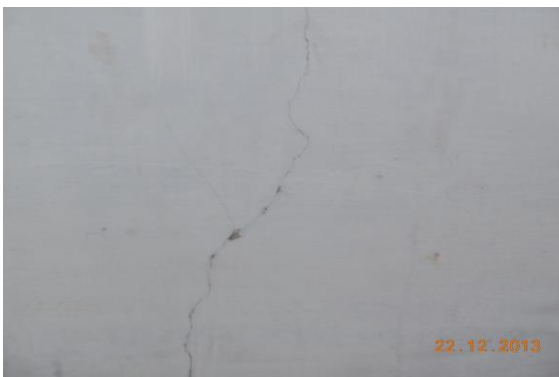
Photo 10

Inclined Crack on Wall No. 2 of Hall No. 3, House Above Shop No.270 & 271, First Floor Approx. Width = 0.25mm, Approx. Length = 2.5m. Distance from Wall No.3 = 4.2m, Height from Floor = 0m.

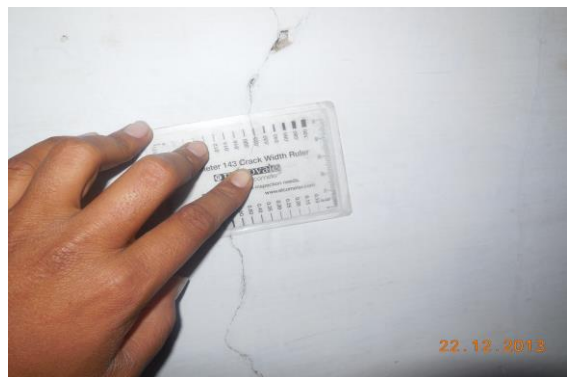
Photo 10A

Inclined Crack on Wall No. 2 of Hall No. 3, House Above Shop No.270 & 271, F/F Approx. Width = 0.25mm, Approx. Length = 2.5m. Distance from Wall No.3 = 4.2m, Height from Floor = 0m.

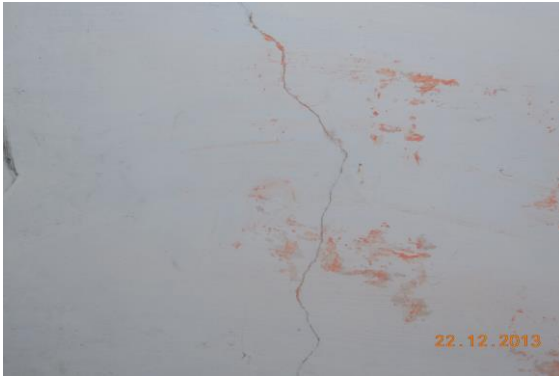
Photo 11

Inclined Crack on Wall No. 2 of Hall No. 3, House Above Shop No.270 & 271, First Floor Approx. Width = 0.6mm, Approx. Length = 2m. Distance from Wall No.3 = 1.5m, Height from Floor = 0m.

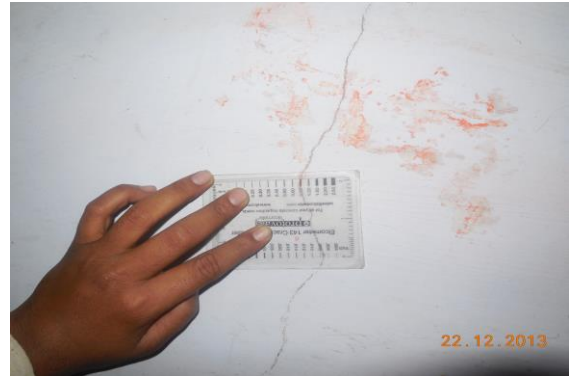
Photo 11A

Inclined Crack on Wall No. 2 of Hall No. 3, House Above Shop No.270 & 271, First Floor Approx. Width = 0.6mm, Approx. Length = 2m. Distance from Wall No.3 = 1.5m, Height from Floor = 0m.

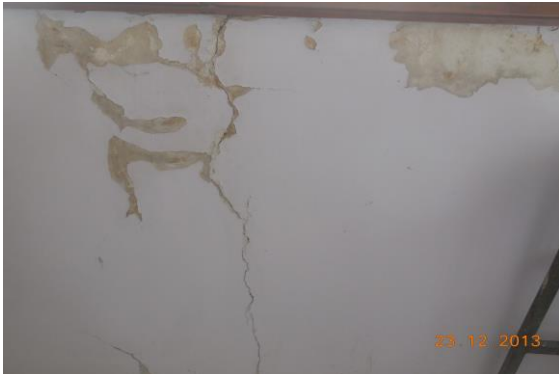
Photo 12

Inclined Crack on Wall No. 1 of Lobby No.1, House NO.846, Second Floor Approx. Width = 0.4mm, Approx. Length = 1m. Distance from Wall No.3 = 1m, Height from Floor = 0.1m.

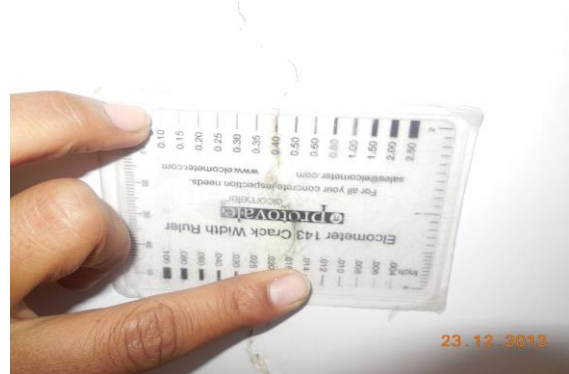
Photo 12A

Inclined Crack on Wall No. 1 of Lobby No.1, House NO.846, Second Floor Approx. Width = 0.4mm, Approx. Length = 1m. Distance from Wall No.3 = 1m, Height from Floor = 0.1m.

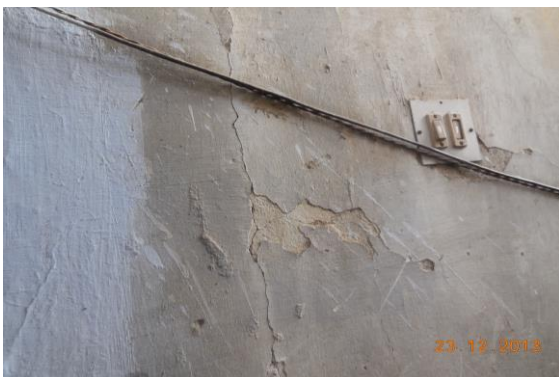
Photo 13

Vertical Crack on Wall No. 1 of Staircase First Floor to Second Floor, Third Floor Approx. Width = 0.35mm, Approx. Length = 2m. Distance from Wall No.3 = 0.3m, Height from Floor = 1m.

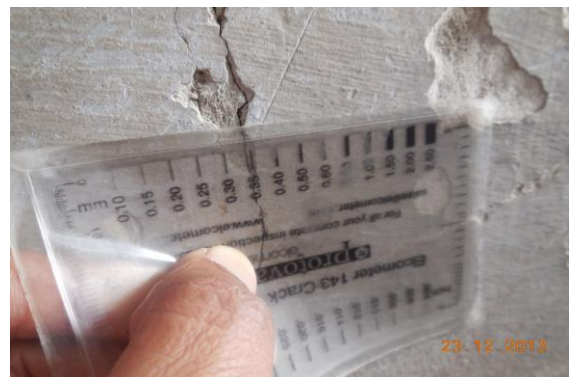
Photo 13A

Vertical Crack on Wall No. 1 of Staircase First Floor to Second Floor, Third Floor Approx. Width = 0.35mm, Approx. Length = 2m. Distance from Wall No.3 = 0.3m, Height from Floor = 1m.

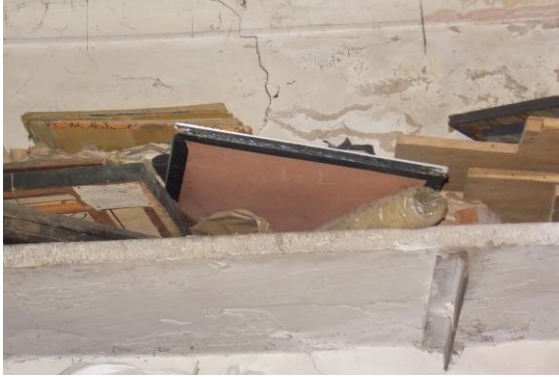
Photo 14

Inclined Crack on Wall No. 4 of Part B of Shop No.271, Ground Floor
Approx. Width = 2mm, Approx. Length = 3m. Distance from Wall No.1 = 1.2m, Height from Floor = 0m.

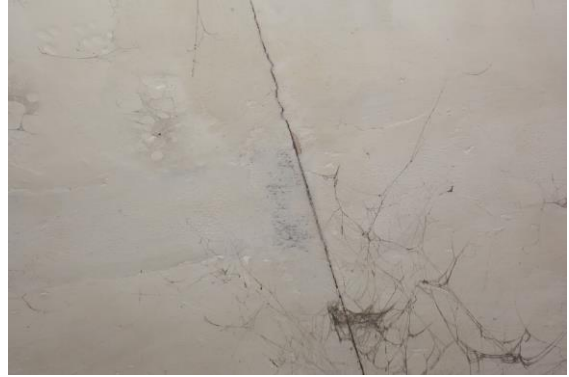
Photo 15

Horizontal Crack on Roof of Part B of Shop No.271, Ground Floor
Approx. Width = 3mm, Approx. Length = 2.5m. Distance from Wall No.1 = 1.2m, Height from Floor = 3.5m.

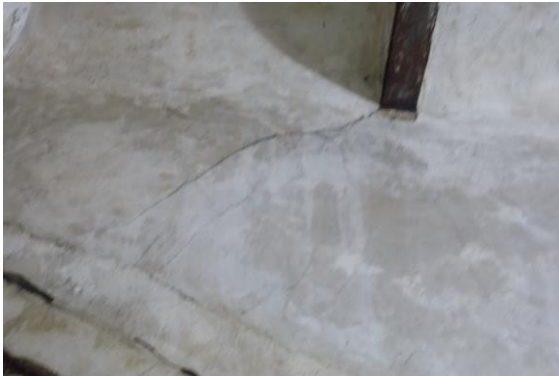
Photo 16

Inclined Crack on Wall No. 2 of Part A of Shop No.271, Ground Floor
Approx. Width = 0.25mm, Approx. Length = 0.6m. Distance from Wall No.4 = 0.2m, Height from Floor = 2.5m.

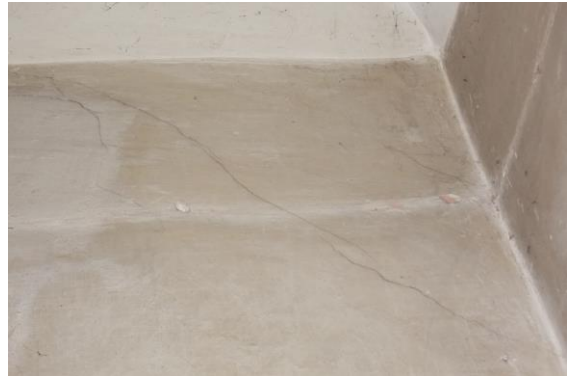
Photo 17

Inclined Crack on Wall No. 3 of Part A of Shop No.271, Ground Floor
Approx. Width = 0.25mm, Approx. Length = 1.5m. Distance from Wall No.1 = 0.05m, Height from Floor = 2m.

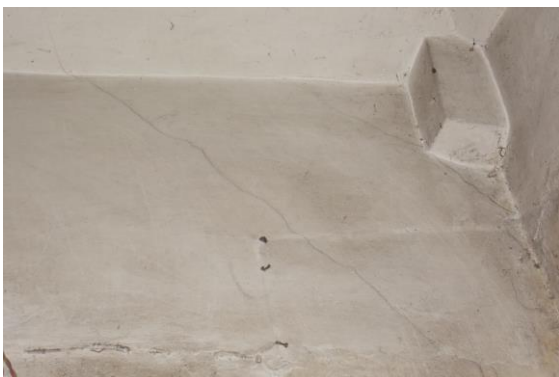
Photo 18

Inclined Crack on Wall No. 4 of Part A of Shop No.271, Ground Floor
Approx. Width = 0.35mm, Approx. Length = 1m. Distance from Wall No.2 = 0.1m, Height from Floor = 2m.

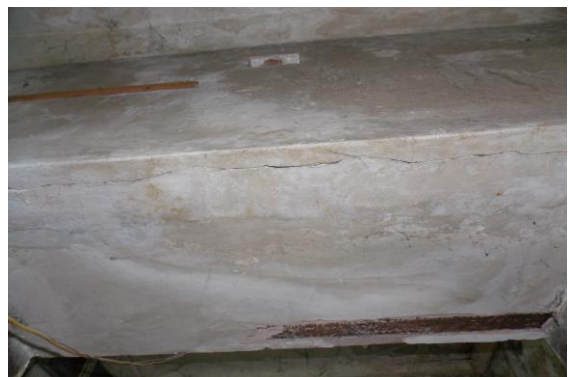
Photo 19

Horizontal Crack on Main Door of Part B of Shop No.271, Ground Floor
Approx. Width = 1mm, Approx. Length = 3m. Distance from Wall No.1 = 0.7m, Height from Floor = 2m.

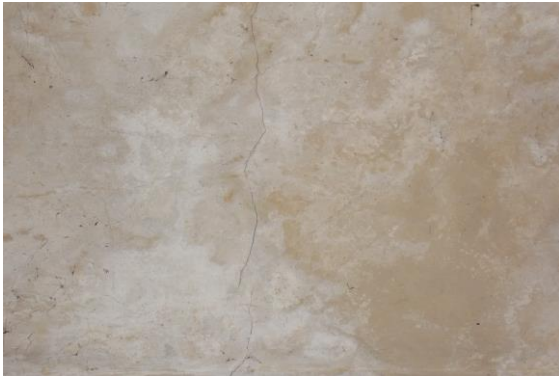
Photo 20

Horizontal Crack on Roof of Part A of Shop No.271, Ground Floor
Approx. Width = 0.35mm, Approx. Length = 0.8m. Distance from Wall No.1 = 1.5m, Height from Floor = 4m.

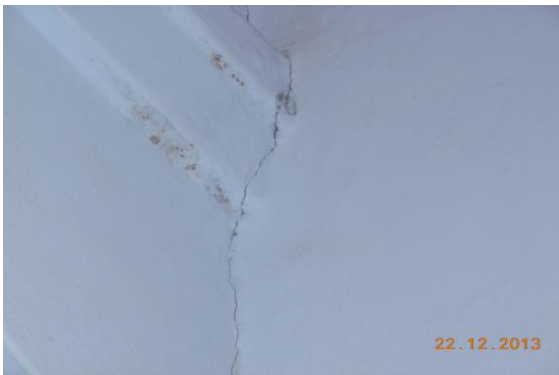
Photo 22

Peeling of Plaster on Wall No. 2 of Lobby No.1 of House Above Shop No.270 & 271, First Floor

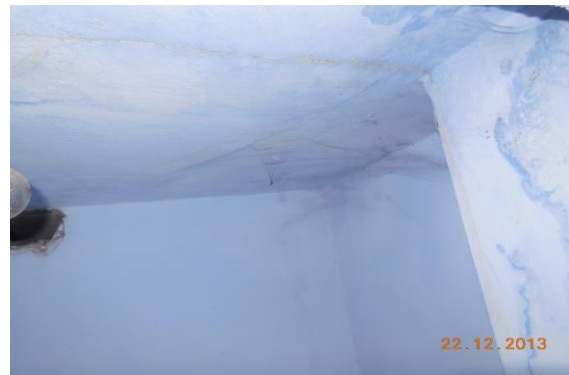
Photo 23

Dampness/Seepage on Wall No. 2 & Roof of Toilet No. 1 of House Above Shop No.270 & 271, First Floor

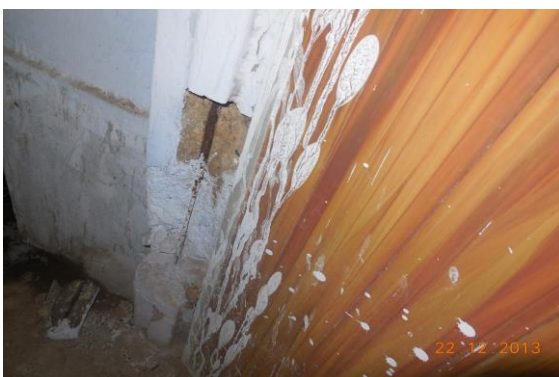
Photo 24

Damaged Portion on Wall No. 2 of Toilet No. 1 of House Above Shop No.270 & 271, First Floor

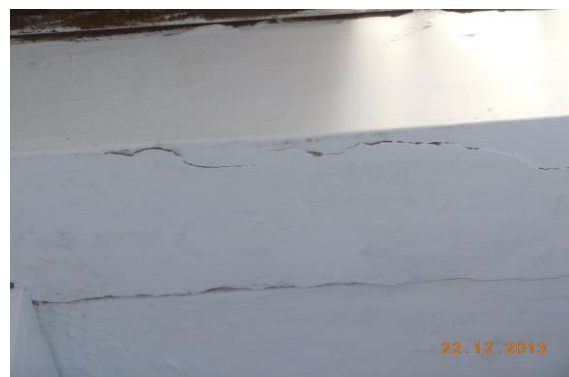
Photo 25

Peeling of Plaster on Roof of Lobby No.1 of House Above Shop No.270 & 271, First Floor

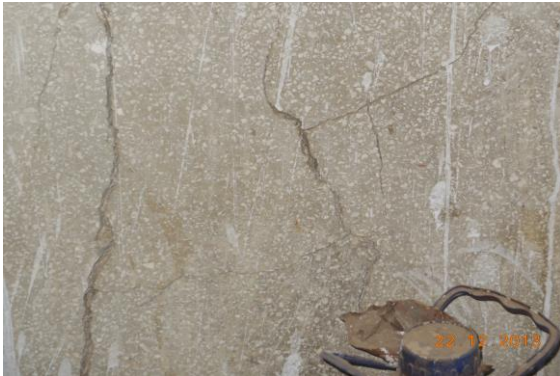
Photo 26

Damaged Portion on Wall No. 4 of Toilet No. 1 of House Above Shop No.270 & 271, First Floor

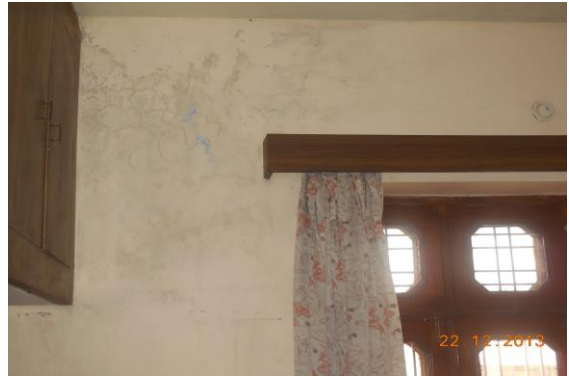
Photo 27

Dampness/Seepage on Wall No. 4 of Room No. 1 of House Above Shop No.270 & 271, First Floor

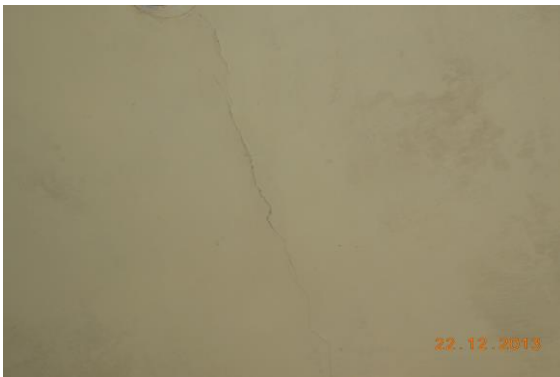
Photo 28

Peeling of Plaster on Roof of Passage No.2 of House Above Shop No.270 & 271, First Floor

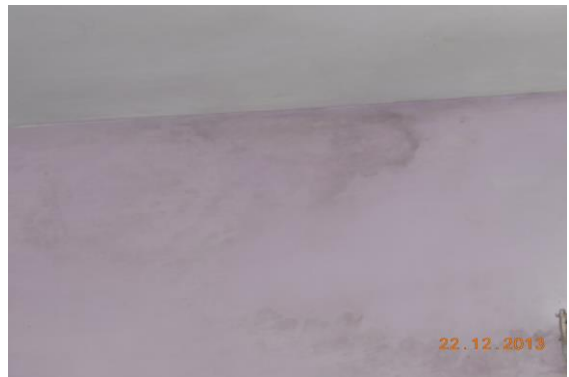
Photo 29

Dampness/Seepage on Wall No. 2 & Roof of Room No. 2 of House Above Shop No.270 & 271, First Floor

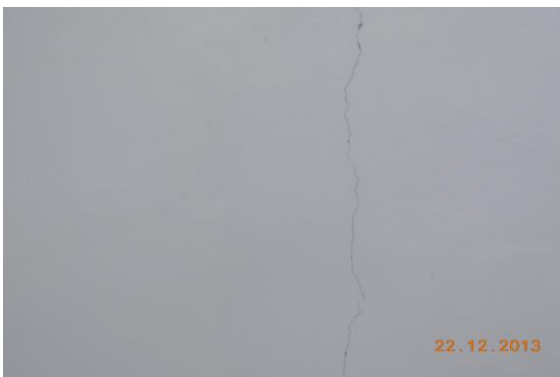
Photo 30

Peeling of Plaster on Roof of Room No. 2 of House Above Shop No.270 & 271, First Floor

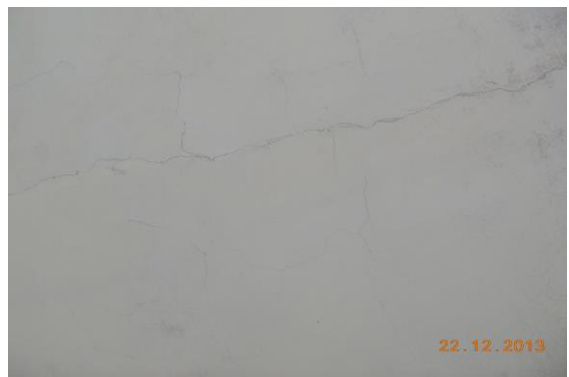
Photo 31

Peeling of Plaster on Roof of Hall No. 2 of House Above Shop No.270 & 271, First Floor

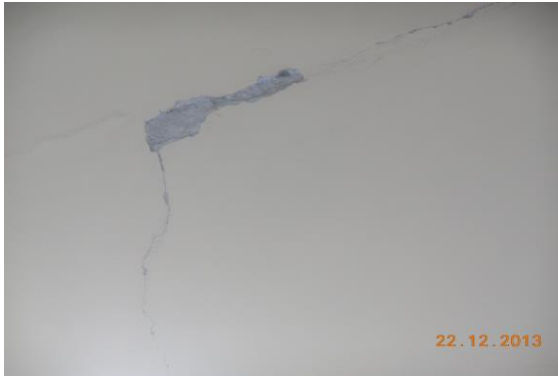
Photo 32

Peeling of Plaster on Wall No. 2 of Hall No. 2 of House Above Shop No.270 & 271, First Floor

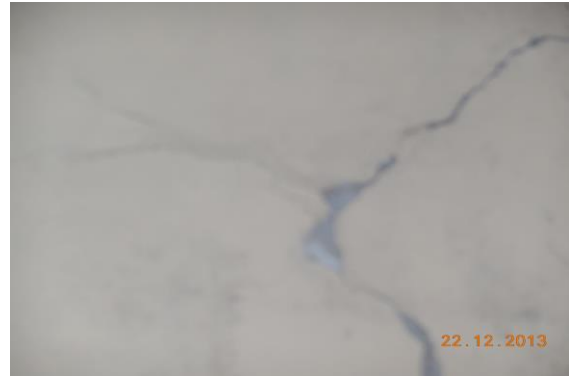
Photo 33

Peeling of Plaster on Wall No. 1 of Hall No. 2 of House Above Shop No.270 & 271, First Floor

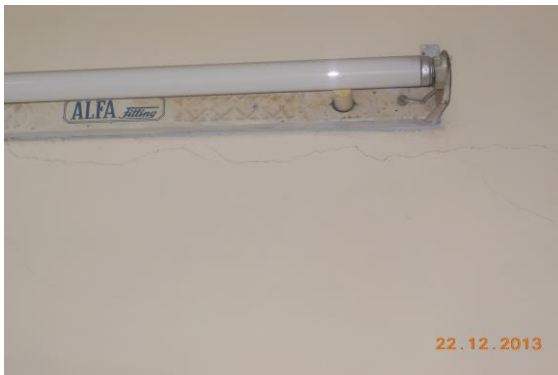
Photo 34

Peeling of Plaster on Wall No. 2 of Hall No. 2 of House Above Shop No.270 & 271, First Floor

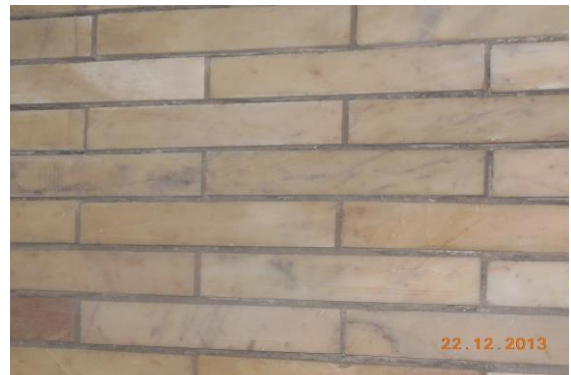
Photo 35

Peeling of Plaster on Wall No. 4 of Hall No. 2 of House Above Shop No.270 & 271, First Floor

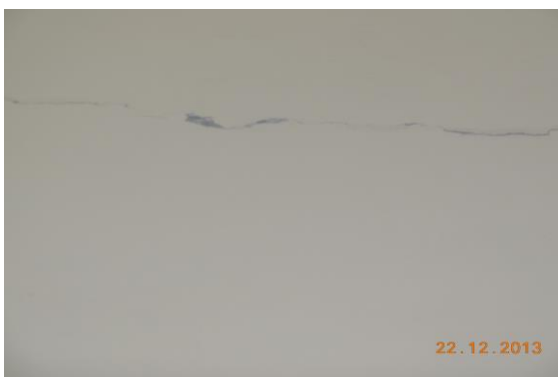
Photo 36

Peeling of Plaster on Wall No. 3 of Hall No. 2 of House Above Shop No.270 & 271, First Floor

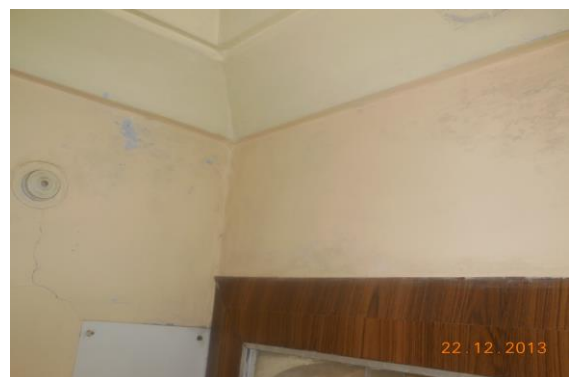
Photo 37

Dampness/Seepage on Wall No. 4 & 1 of Hall No. 1 of House Above Shop No.270 & 271, First Floor

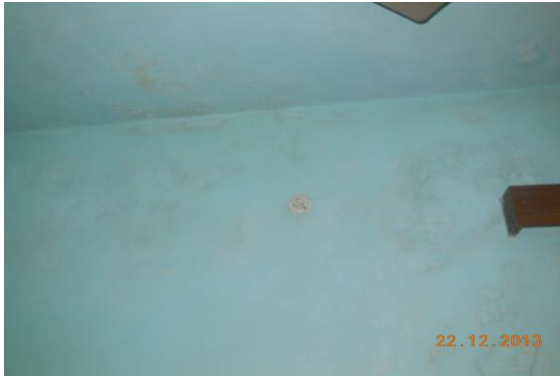
Photo 38

Dampness/Seepage on Wall No. 1 & Roof of Room No. 3 of House Above Shop No.270 & 271, First Floor

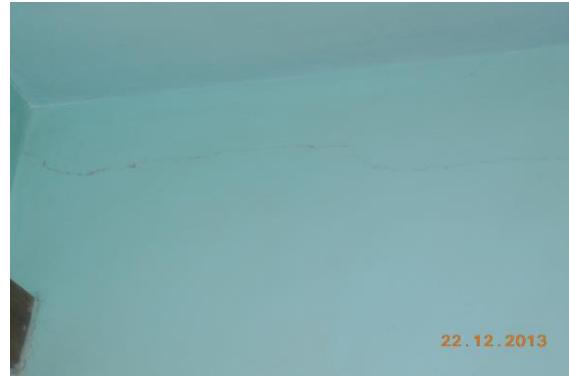
Photo 39

Peeling of Plaster on Wall No. 4 of Room No. 3 of House Above Shop No.270 & 271, First Floor

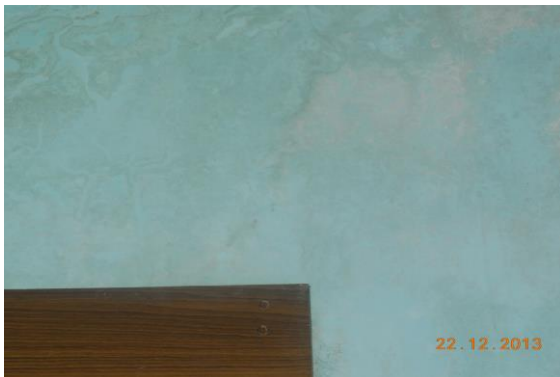
Photo 40

Dampness/Seepage on Wall No. 2 of Room No. 3 of House Above Shop No.270 & 271, First Floor

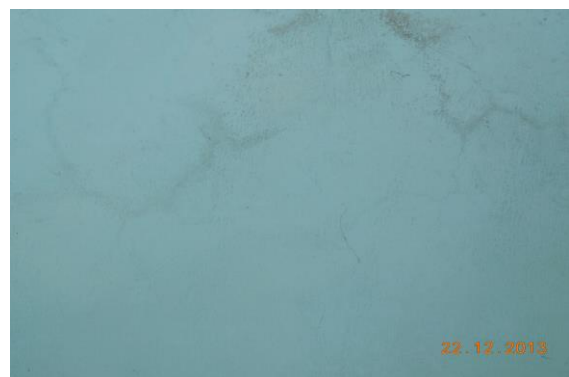
Photo 43

Dampness/Seepage on Roof of Toilet No. 2 of House Above Shop No.270 & 271, First Floor

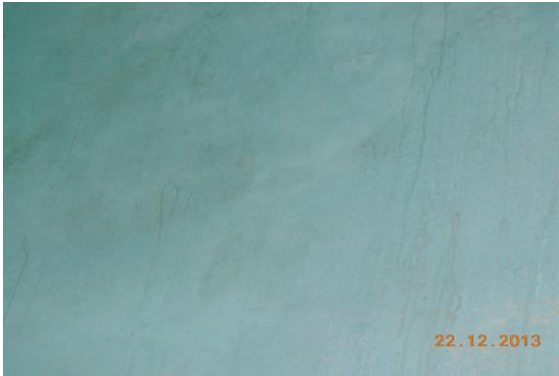
Photo 44

Dampness/Seepage on Wall No. 2 of Toilet No. 2 of House Above Shop No.270 & 271, First Floor

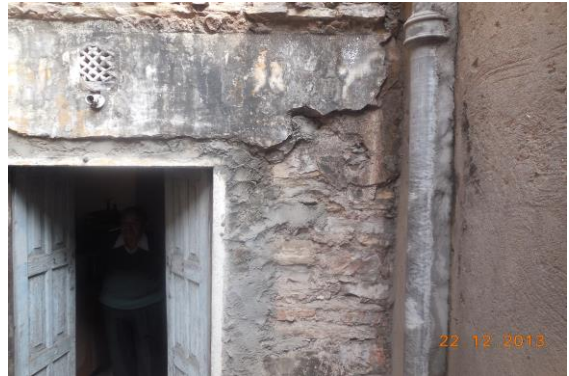
Photo 45

Damaged Portion on Wall No. 3 of Open Sky of House Above Shop No.270 & 271, First Floor

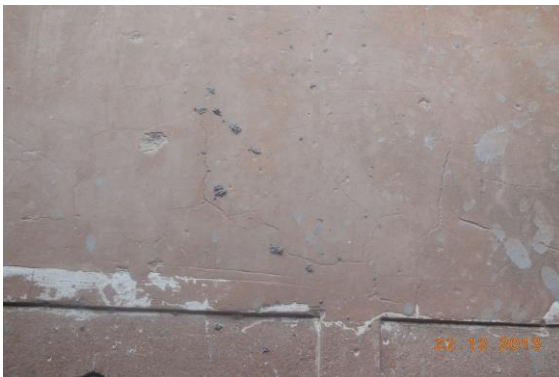
Photo 46

Peeling of Plaster on Wall No. 2 of Open Sky of House Above Shop No.270 & 271, First Floor

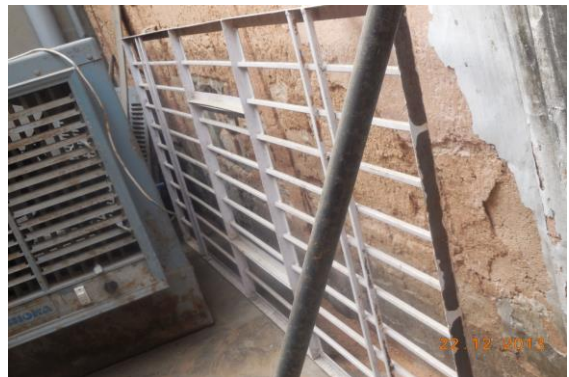
Photo 47

Peeling of Plaster on Wall No. 2 of Open Sky of House Above Shop No.270 & 271, First Floor

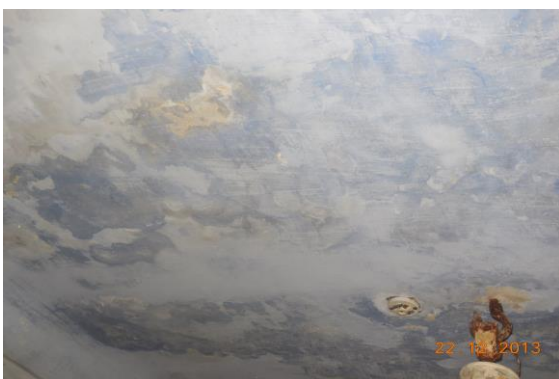
Photo 48

Dampness/Seepage on Roof of Store No.1 of House Above Shop No.270 & 271, First Floor

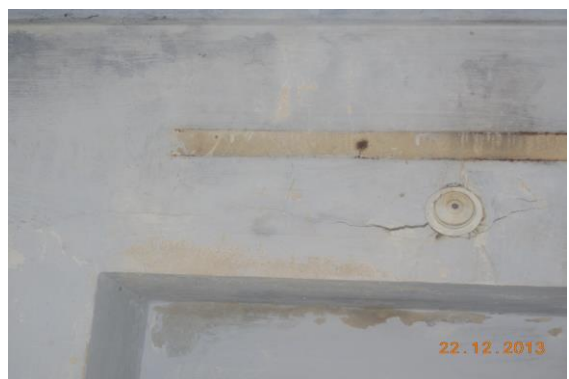
Photo 49

Peeling of Plaster on Wall No. 1 of Store No.1 of House Above Shop No.270 & 271, First Floor

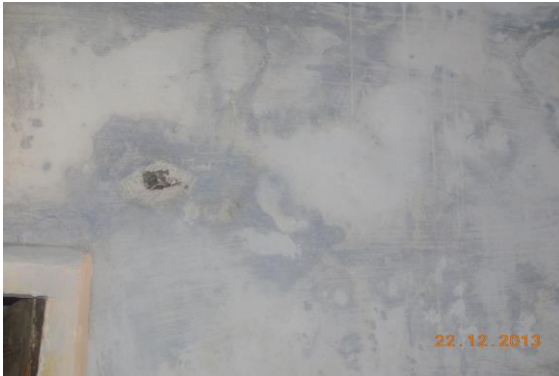
Photo 50

Dampness/Seepage on Wall No. 3 of Store No.1 of House Above Shop No.270 & 271, First Floor

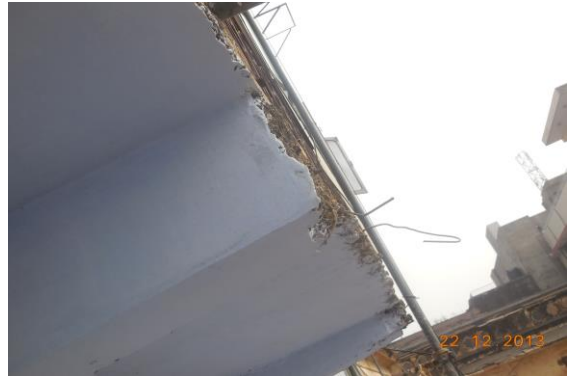
Photo 51

Damaged Portion on Shade of Balcony of House Above Shop No.270 & 271, First Floor

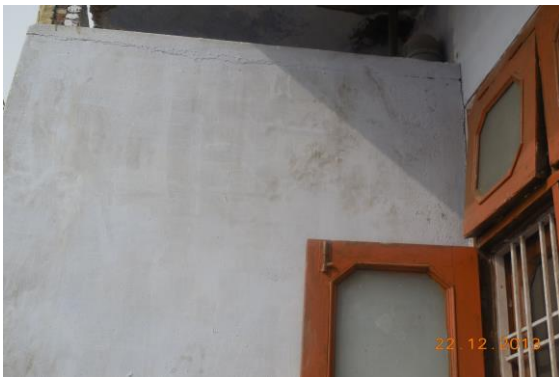
Photo 52

Dampness/Seepage on Wall No. 2 of Balcony of House Above Shop No.270 & 271, First Floor

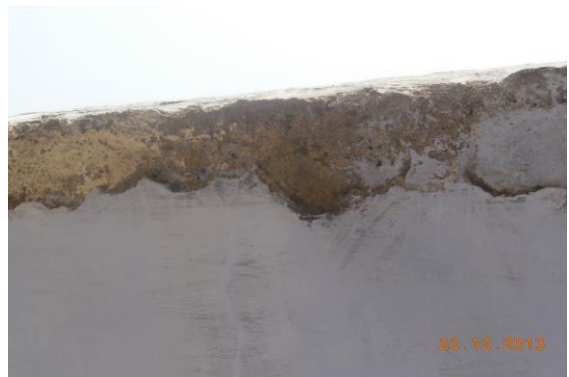
Photo 53

Dampness/Seepage on Shade of Balcony of House Above Shop No.270 & 271, First Floor

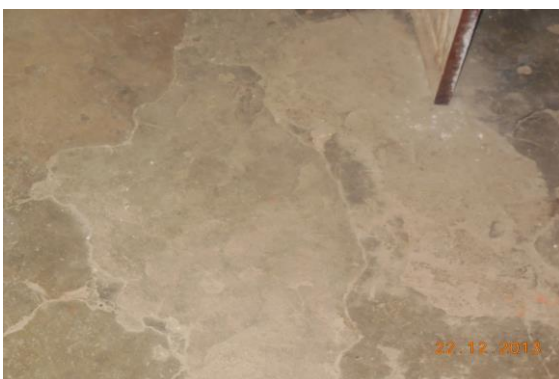
Photo 54

Peeling of Plaster on Floor of Lobby No.3 of House Above Shop No.270 & 271, First Floor

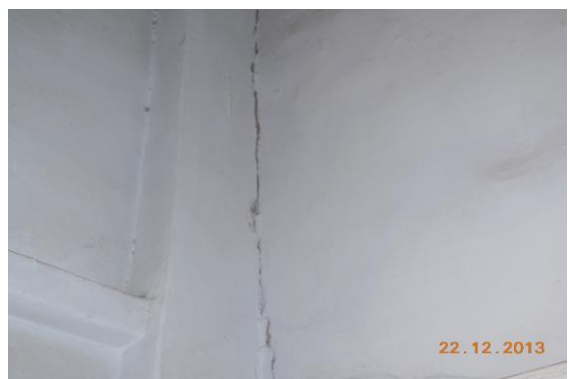
Photo 55

Peeling of Plaster on Wall No. 2 & 4 of Hall No. 3 of House Above Shop No.270 & 271, First Floor

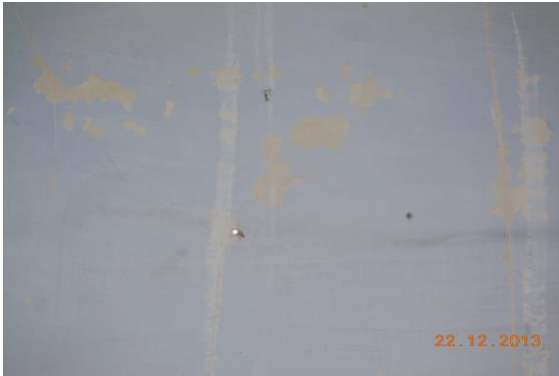
Photo 56

Peeling of Plaster on Wall No. 1 of Hall No. 3 of House Above Shop No.270 & 271, First Floor

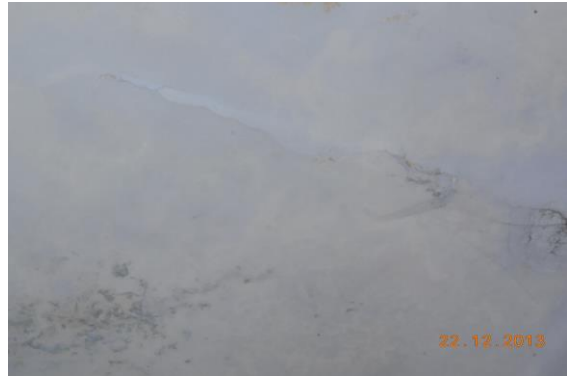
Photo 57

Dampness/Seepage on Roof of Hall No. 3 of House Above Shop No.270 & 271, First Floor

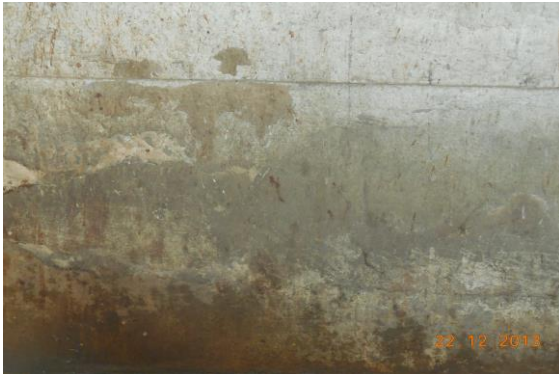
Photo 58

Dampness/Seepage on Wall No. 4 of Lobby No.4 of House Above Shop No.270 & 271, First Floor

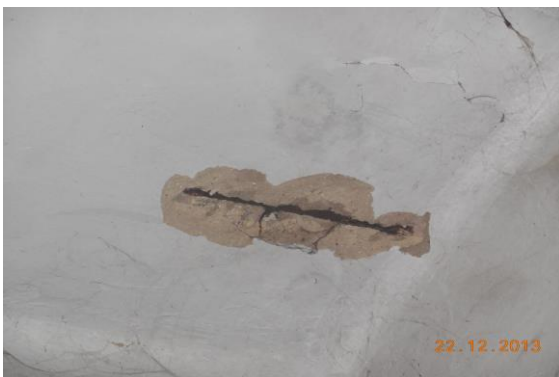
Photo 59

Peeling of Plaster on Wall No. 1 of Lobby No.4 of House Above Shop No.270 & 271, First Floor

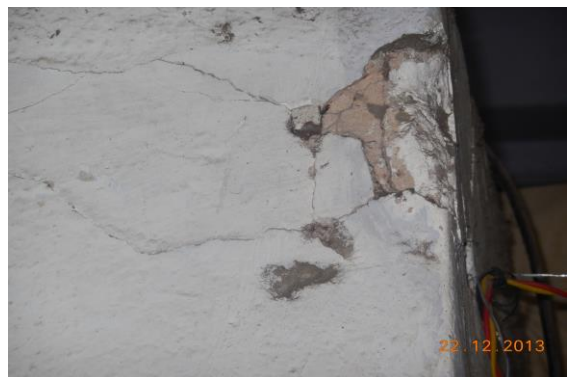
Photo 60

Exposed Reinforcement on Roof of Lobby No.4 of House Above Shop No.270 & 271, First Floor

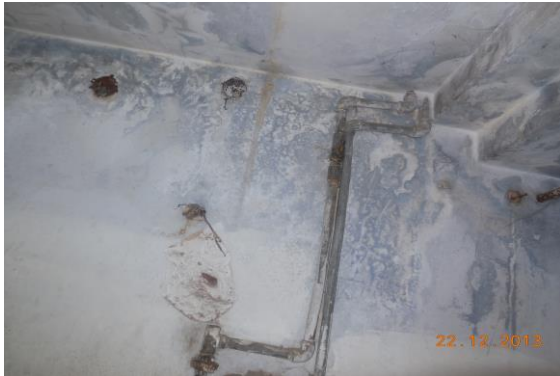
Photo 61

Damaged Portion on Wall No. 3 of Lobby No.4 of House Above Shop No.270 & 271, First Floor

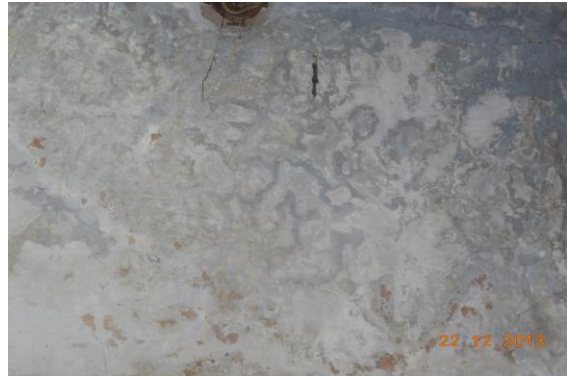
Photo 62

Dampness/Seepage on Wall No. 2, 4 & Roof of Toilet & washroom No.3 of House Above Shop No.270 & 271, First Floor

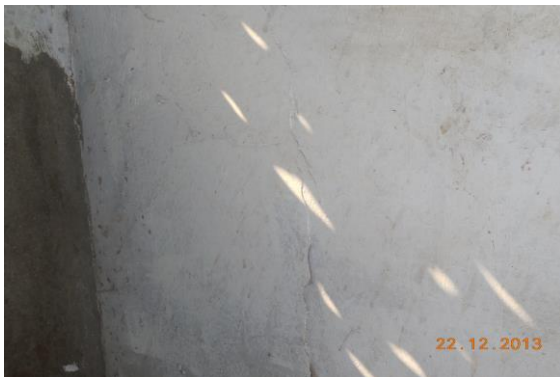
Photo 63

Dampness/Seepage on Wall No. 1 of Toilet & washroom No.3 of House Above Shop No.270 & 271, First Floor

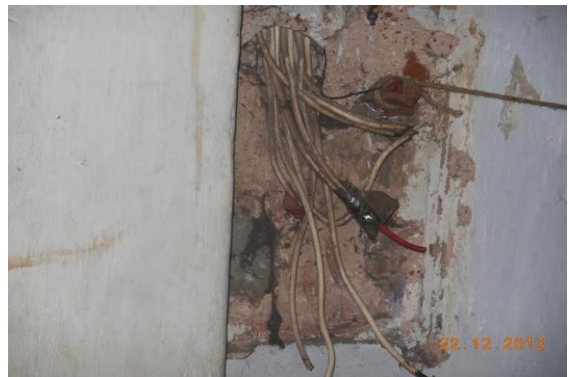
Photo 64

Peeling of Plaster on Wall No. 4 of Toilet & washroom No.3 of House Above Shop No.270 & 271, First Floor

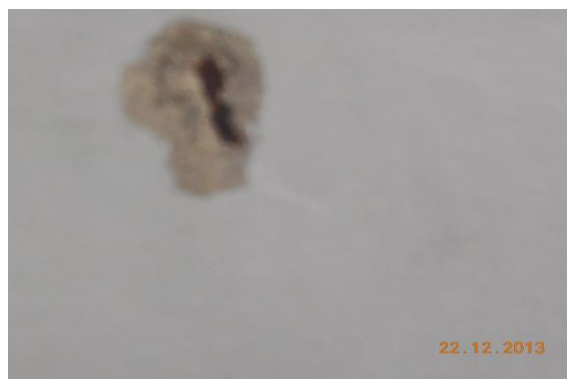
Photo 66

Peeling of Plaster on Wall No. 4 of Room No. 4 of House Above Shop No.270 & 271, First Floor

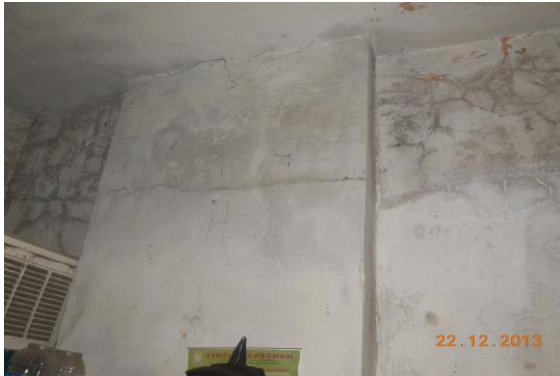
Photo 67

Peeling of Plaster on Roof of Room No. 4 of House Above Shop No.270 & 271, First Floor

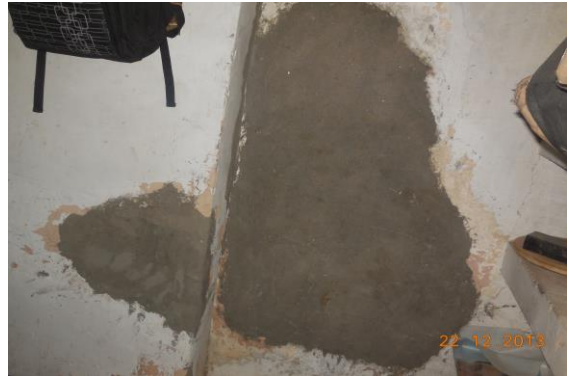
Photo 68

Dampness/Seepage on Wall No. 4 of Room No. 5 of House Above Shop No.270 & 271, First Floor

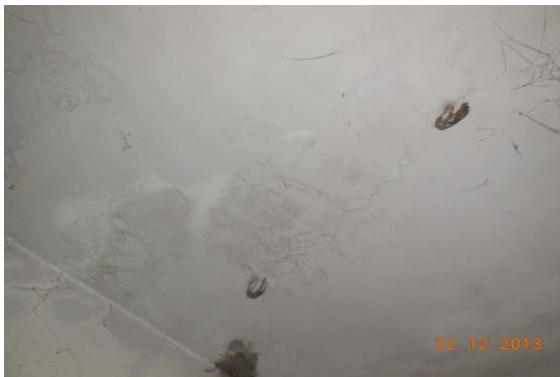
Photo 69

Peeling of Plaster on Wall No. 4 of Room No. 5 of House Above Shop No.270 & 271, First Floor

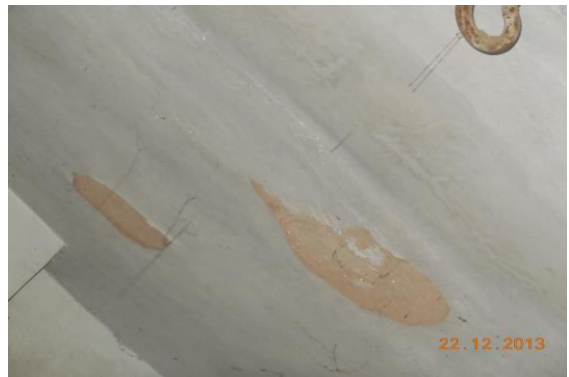
Photo 70

Dampness/Seepage on Roof of Room No. 5 of House Above Shop No.270 & 271, First Floor

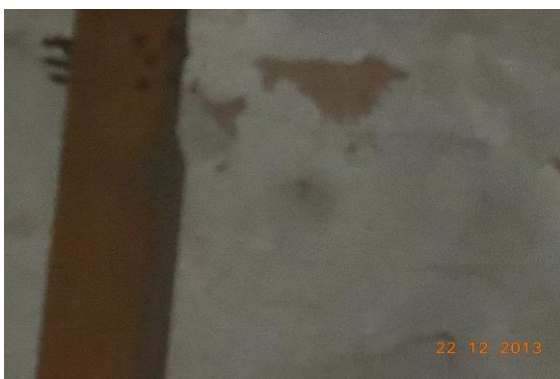
Photo 71

Peeling of Plaster on Roof of Room No. 5 of House Above Shop No.270 & 271, First Floor

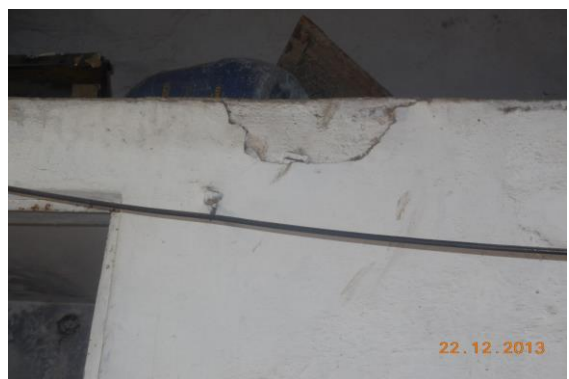
Photo 72

Peeling of Plaster on Wall No. 4 of Room No. 5 of House Above Shop No.270 & 271, First Floor

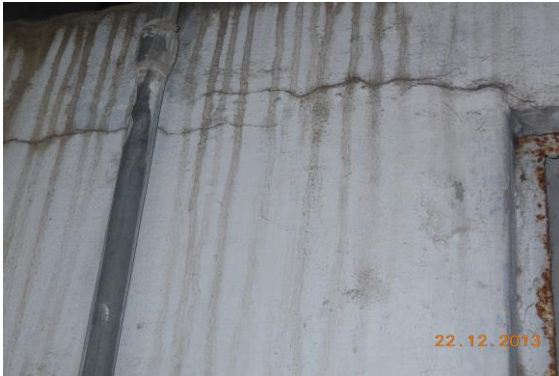
Photo 73

Peeling of Plaster on Wall No. 2 of Lobby No.4 of House Above Shop No.270 & 271, First Floor

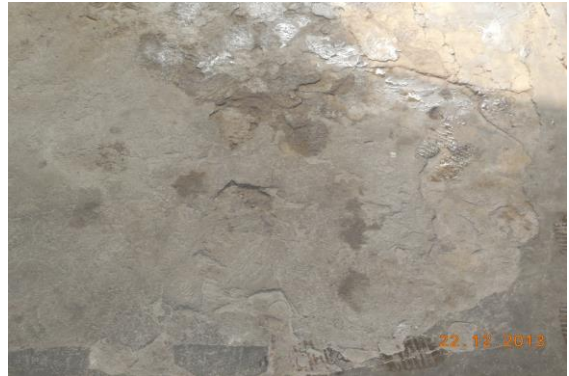
Photo 74

Peeling of Plaster on Wall No. 2 of Lobby No.4 of House Above Shop No.270 & 271, First Floor

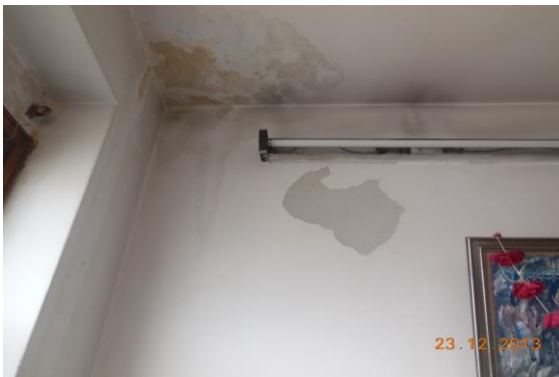
Photo 75

Peeling of Plaster on Wall No. Floor of Lobby No.4 of House Above Shop No.270 & 271, First Floor

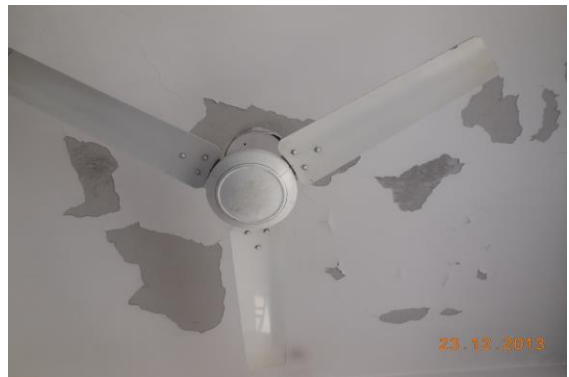
Photo 76

Dampness/Seepage on Wall No. 4 & Roof of Lobby No.1 of House NO.846, Second Floor

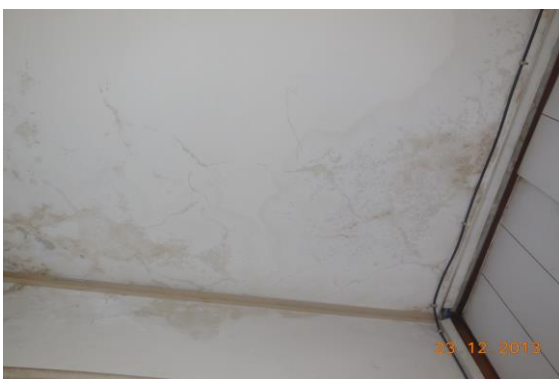
Photo 77

Peeling of Plaster on Roof of Lobby No.1 of House NO.846, Second Floor

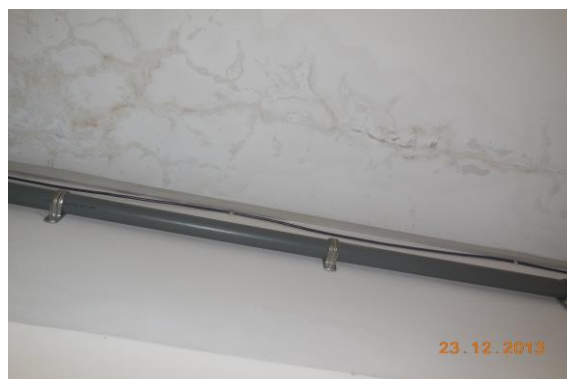
Photo 78

Dampness/Seepage on Roof of Passage of House NO.846, Second Floor

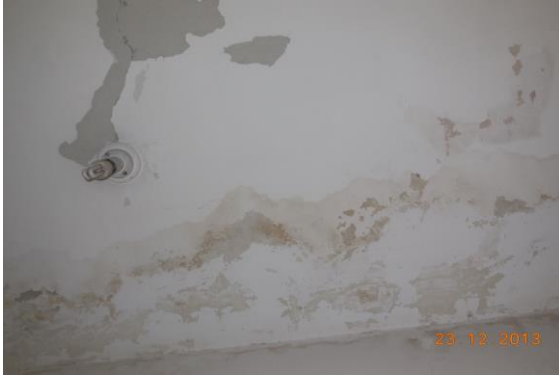
Photo 79

Dampness/Seepage on Roof of Passage of House NO.846, Second Floor

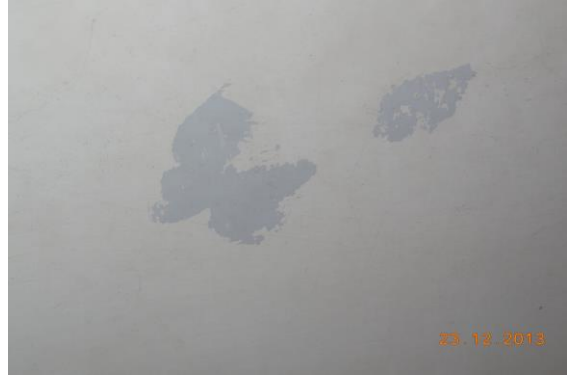
Photo 80

Dampness/Seepage on Roof of Passage of House NO.846, Second Floor

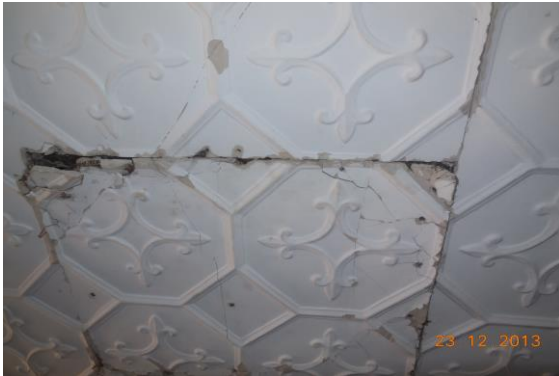
Photo 81

Peeling of Plaster on Wall No. 2 of Passage of House NO.846, Second Floor

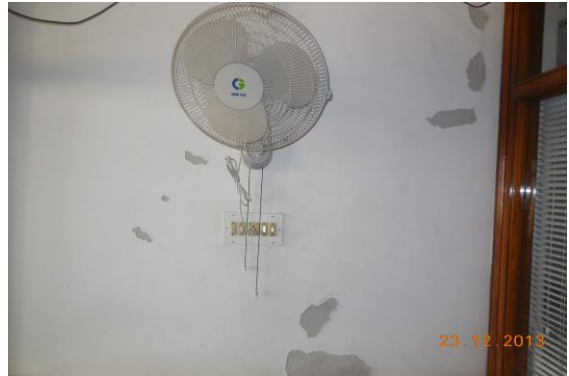
Photo 82

Damaged Portion on Roof of Passage No.2 of House NO.846, Second Floor

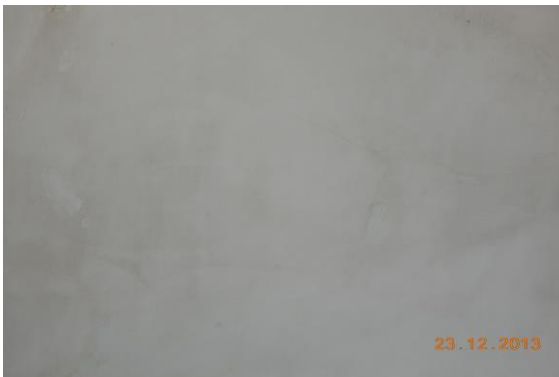
Photo 83

Peeling of Plaster on Wall No. 4 of Lobby No.2 of House NO.846, Second Floor

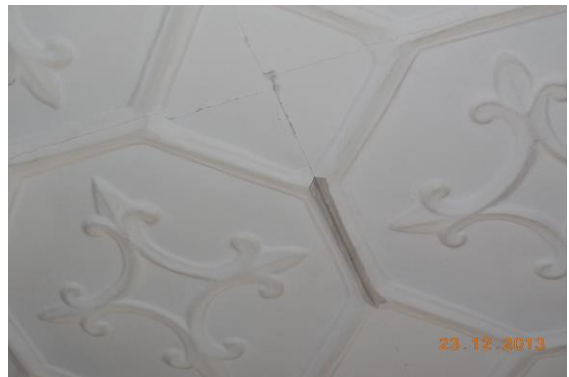
Photo 84

Dampness/Seepage on Wall No. 3 of Hall No. 1 (Part B) of House NO.846, Second Floor
