Pre Building Condition Survey Report

Name and Address of Structure :	Choti Chopar to Badi Chopar (Down Line)
---------------------------------	---

Name of the Project	Contract JMRC-UG1B “Design and Construction of Tunnel between Chandpole and Badi Chouper and reverse line by Shield TBM, Underground Metro Stations at Choti Chouper and Badi Chouper by Cut and Cover Methods on East West Corridor of Jaipur Metro Rail Corporation Limited .”	
Owner :

Pre Building Condition Survey Report Choti Chopar to Badi Chopar (Down Line)

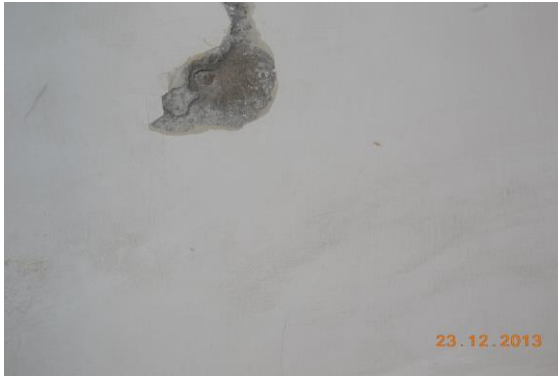
Photo 85

Peeling of Plaster on Roof of Hall No. 1 (Part M) of House NO.846, Second Floor

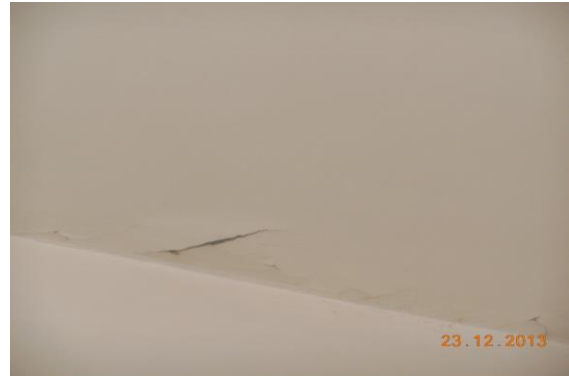
Photo 86

Peeling of Plaster on Wall No. 2 of Hall No. 1 (Part B) of House NO.846, Second Floor

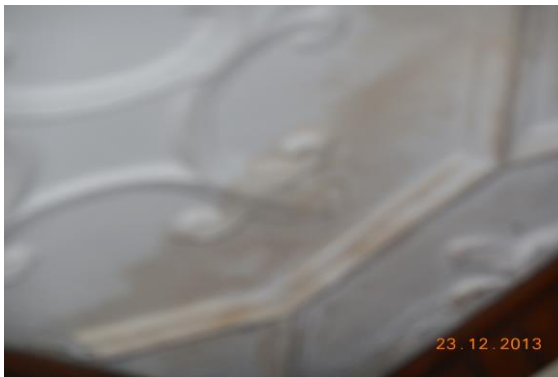
Photo 87

Peeling of Plaster on Roof of Room No. 1 of Second Floor

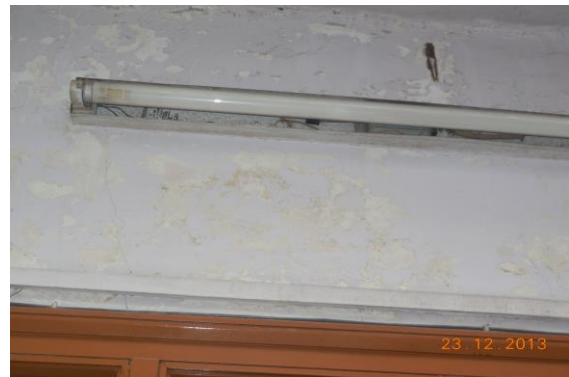
Photo 88

Dampness/Seepage on Roof of Hall No. 2 (Part A) of

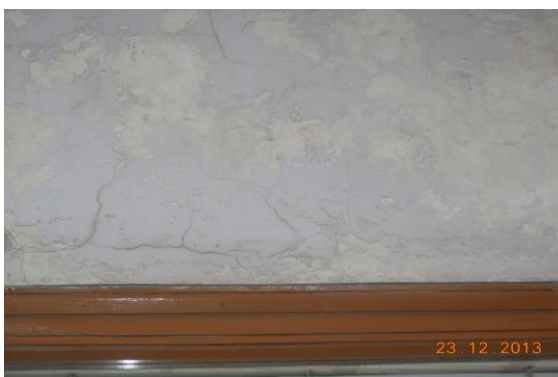
Photo 89

Dampness/Seepage on All Walls of Lobby No.3 of House NO.846, Second Floor

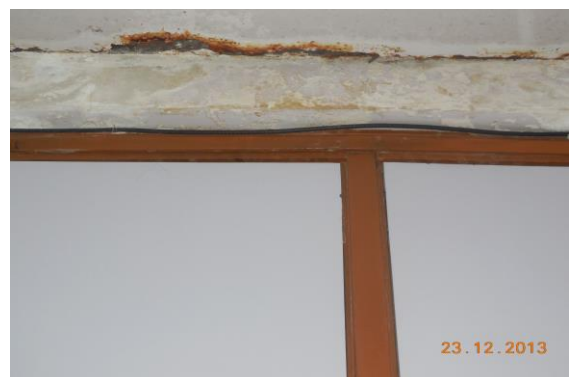
Photo 90

Dampness/Seepage on All Walls of Lobby No.3 of House NO.846, Second Floor

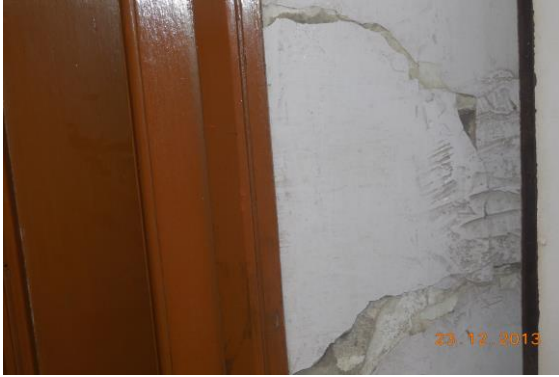
Photo 91

Dampness/Seepage on All Walls of Lobby No.3 of House NO.846, Second Floor

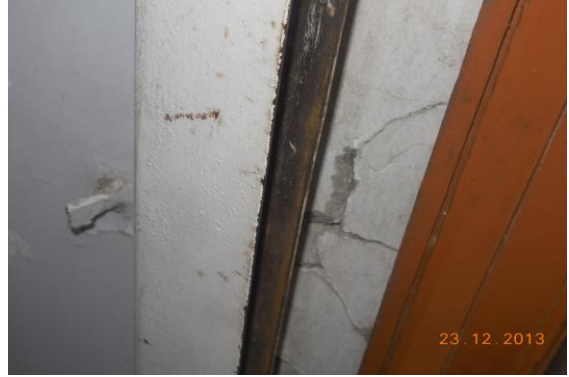
Photo 92

Peeling of Plaster on Wall No. 2 of Lobby No.3 of House NO.846, Second Floor

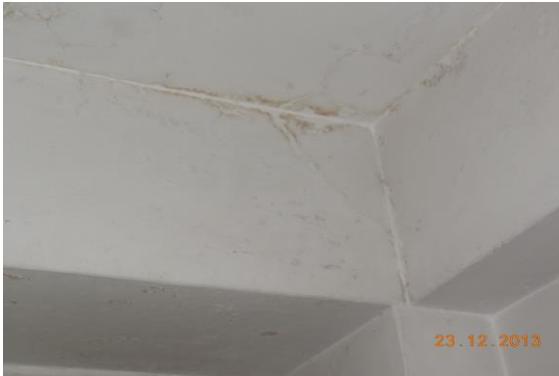
Photo 93

Peeling of Plaster on Wall No. 2 of Lobby No.3 of House NO.846, Second Floor

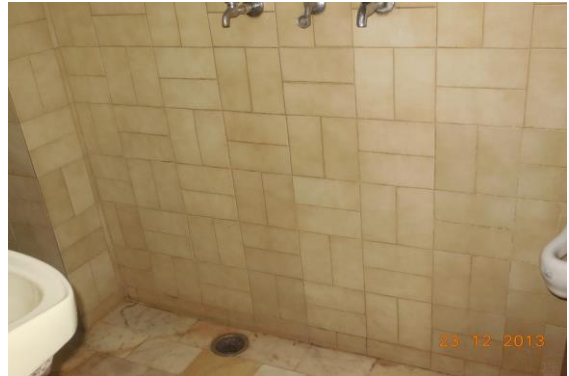
Photo 94

Dampness/Seepage on Wall No. 1, 4 & Roof of Toilet No. 1 of House NO.846, Second Floor

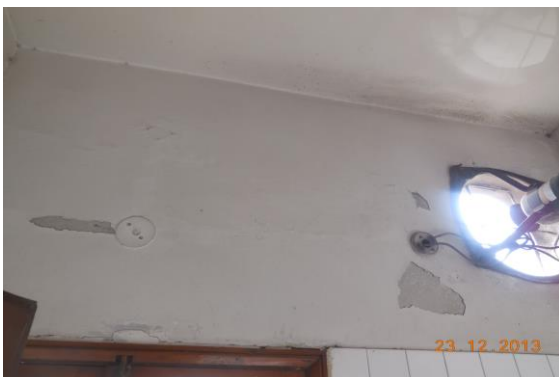
Photo 95

Peeling of Plaster on Wall No. 4 of Toilet No. 1 of House NO.846, Second Floor

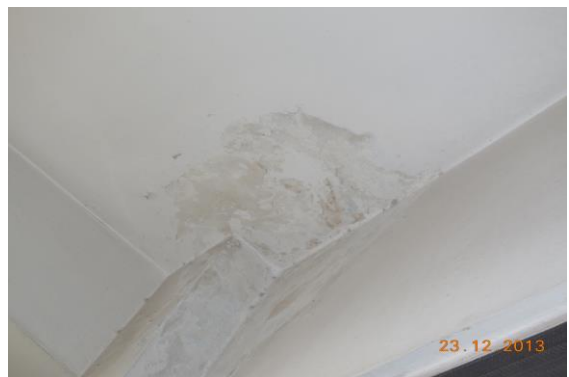
Photo 96

Peeling of Plaster on Wall No. 4 of Toilet No. 2 of House NO.846, Second Floor

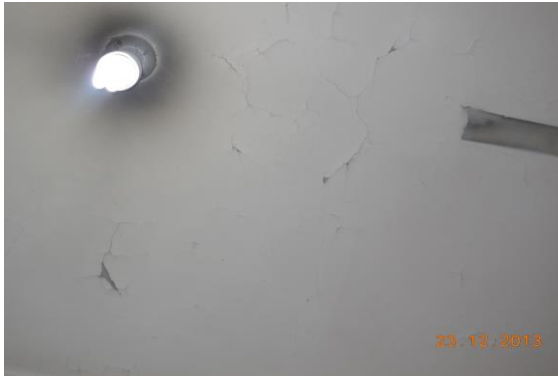
Photo 97

Dampness/Seepage on Wall No. Roof & 3 of Toilet No. 2 of House NO.846, Second Floor

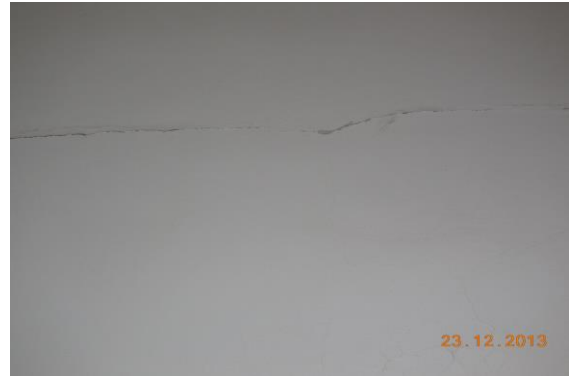
Photo 98

Peeling of Plaster on Roof of Passage No.2 of House NO.846, Second Floor

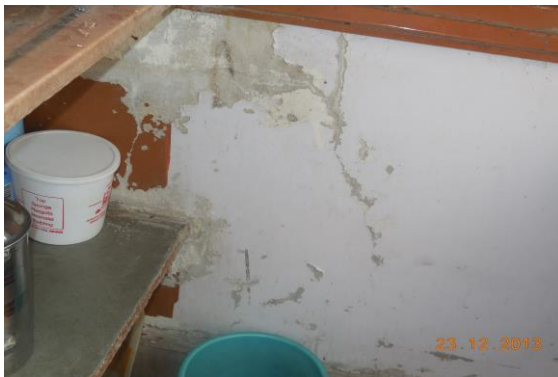
Photo 99

Peeling of Plaster on Wall No. 1 of Passage No.2 of Second Floor

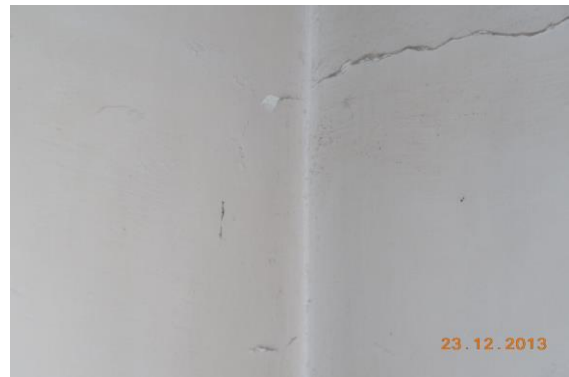
Photo 100

Dampness/Seepage on Wall No. 4 of Kitchen of Second Floor

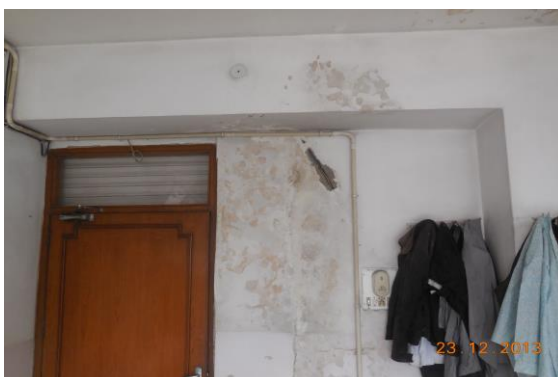
Photo 101

Peeling of Plaster on Wall No. 1 & 4 of Kitchen of Second Floor

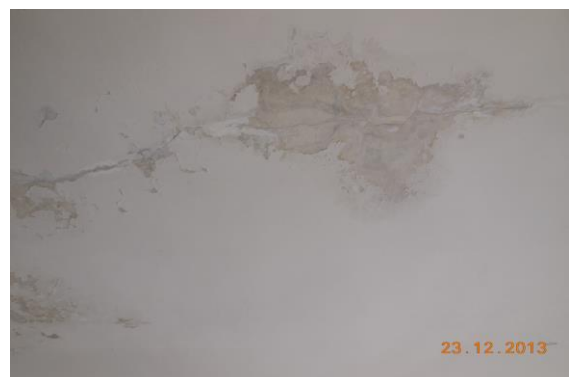
Photo 102

Dampness/Seepage on Wall No. 1 of Hall No. 4 of House NO.846, Second Floor

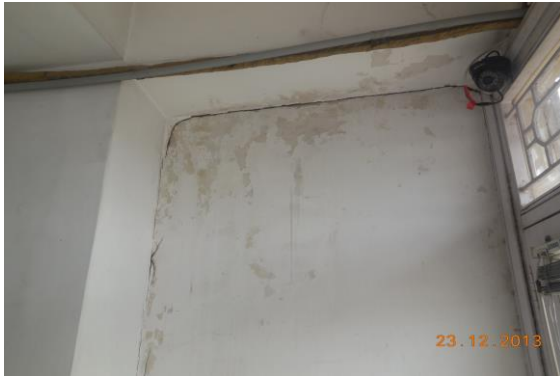
Photo 103

Dampness/Seepage on Roof of Hall No. 4 of House NO.846, Second Floor

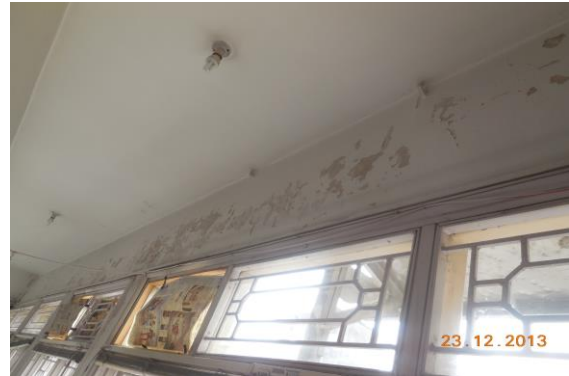
Photo 104

Dampness/Seepage on Wall No. 4 of Hall No. 4 of House NO.846, Second Floor

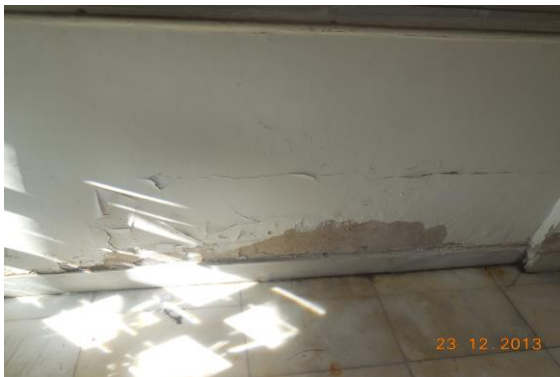
Photo 105

Dampness/Seepage on Wall No. 2 of Hall No. 4 of House NO.846, Second Floor

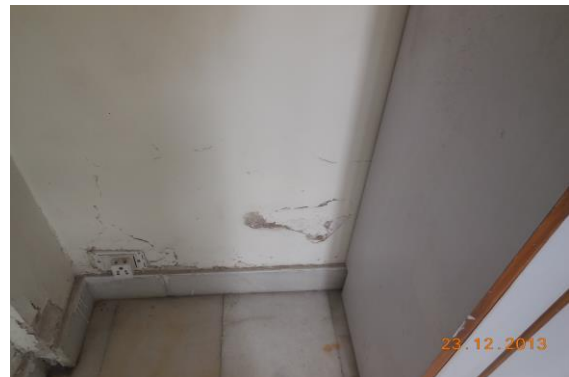
Photo 106

Peeling of Plaster on Wall No. 1 of Lobby of House NO.846, Second Floor

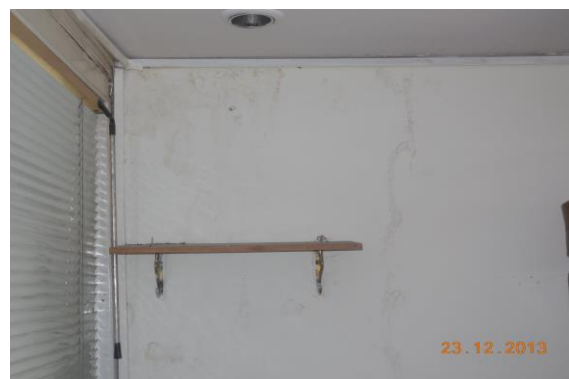
Photo 108

Dampness/Seepage on Wall No. 1 (Part B) of House NO.846, Third Floor

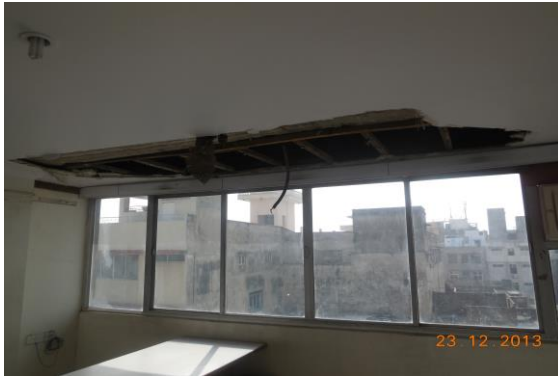
Photo 109

Dampness/Seepage on Wall No. 1 of Room No. 2 of House NO.846, Third Floor

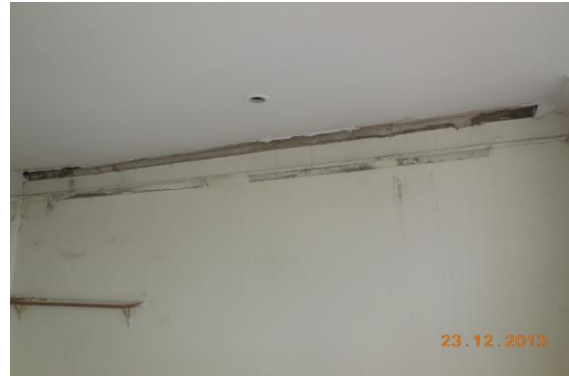
Photo 110

Damaged Portion on Roof of Hall No. 3 of House NO.846, Third Floor

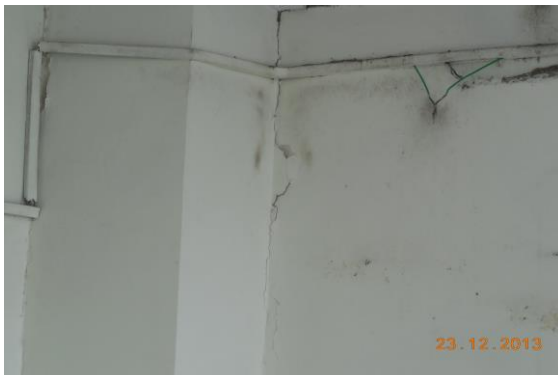
Photo 111

Damaged Portion on Roof of Hall No. 3 of House NO.846, Third Floor

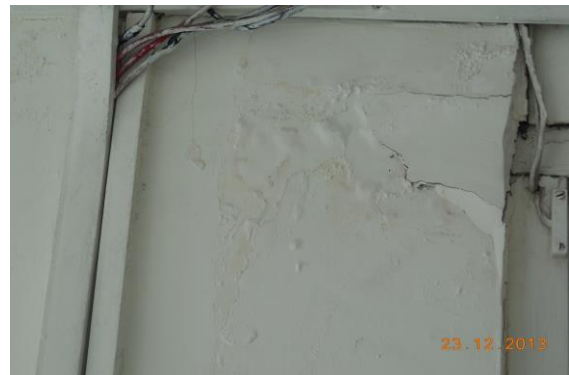
Photo 112

Peeling of Plaster on Wall No. 4 of Hall No. 3 of House NO.846, Third Floor

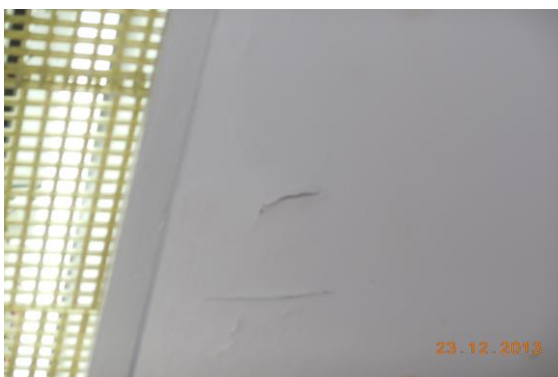
Photo 113

Dampness/Seepage on Wall No. 3 of Hall No. 3 of House NO.846, Third Floor

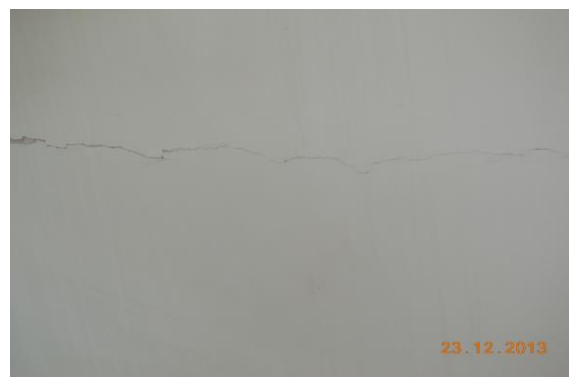
Photo 114

Peeling of Plaster on Roof of Kitchen of House NO.846, Third Floor

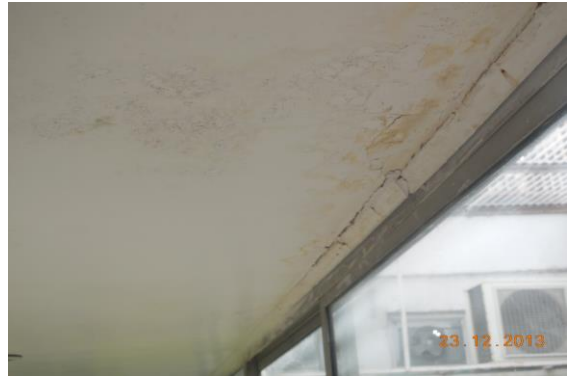
Photo 116

Peeling of Plaster on Roof of Passage of House NO.846, Third Floor

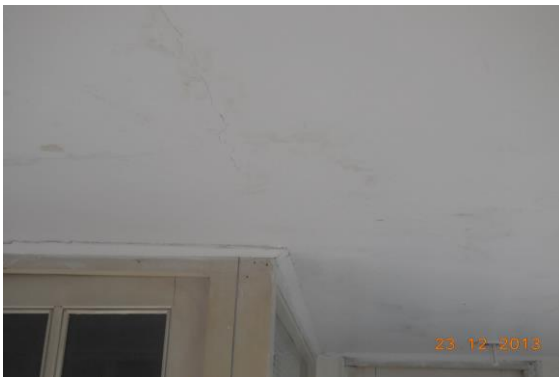
Photo 117

Dampness/Seepage on Roof of Passage of House NO.846, Third Floor

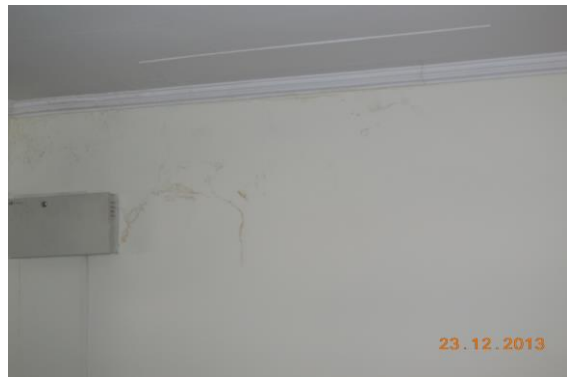
Photo 118

Dampness/Seepage on Roof of House NO.846 of Third Floor

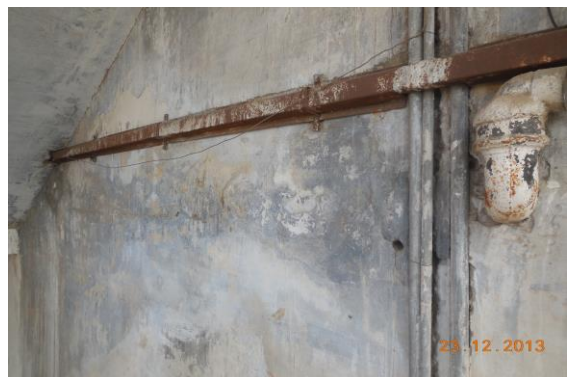
Photo 120

Dampness/Seepage on of Hall No. 4 (Part A) of House NO.846, Third Floor

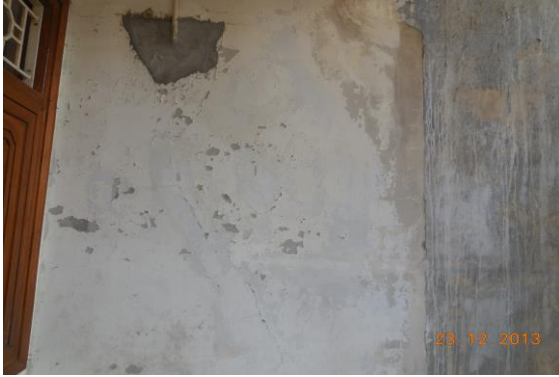
Photo 121

Dampness/Seepage on Wall No. 1 of Staircase Second to Third Floor of Third Floor

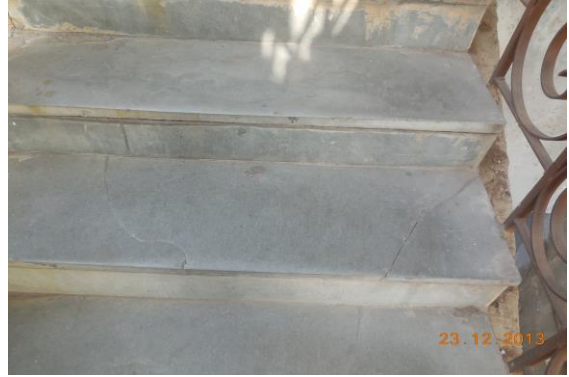
Photo 122

Peeling of Plaster on Wall No. 1 of Staircase Second to Third Floor of Third Floor

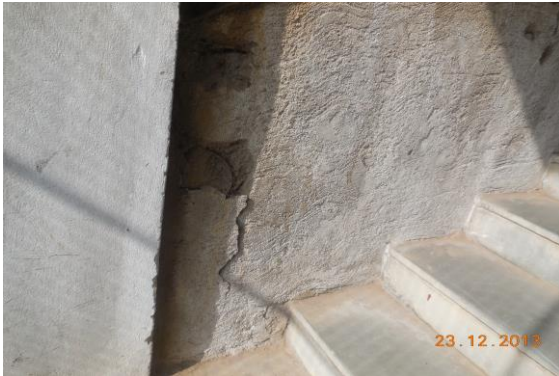
Photo 123

Damaged Portion on Wall No. Steps & Floor of Staircase First Floor to Second Floor of Third Floor

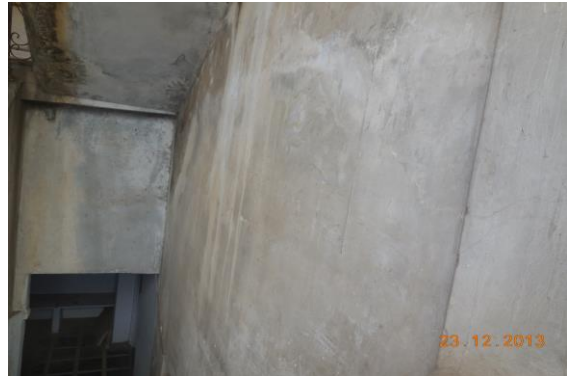
Photo 124

Peeling of Plaster on Wall No. 1 of Staircase First Floor to Second Floor of Third Floor

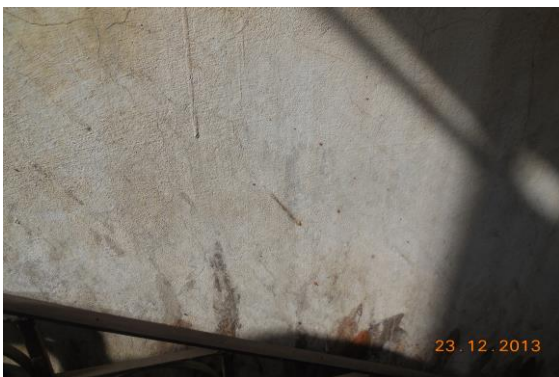
Photo 125

Dampness/Seepage on Wall No. 1 of Staircase First Floor to Second Floor of Third Floor

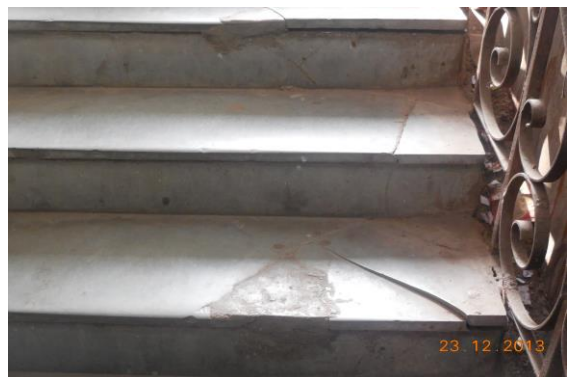
Photo 126

Dampness/Seepage on Wall No. 2 of Staircase First Floor to Second Floor of Third Floor

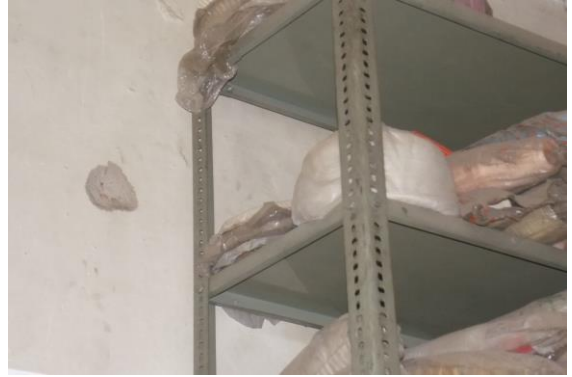
Photo 128

Peeling of Plaster on Roof of Part B of Shop No.271 of Ground Floor

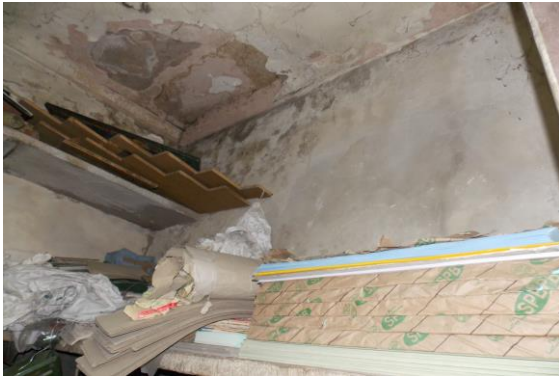
Photo 129

Peeling of Plaster on Wall No. 1 of Part B of Shop No.271 of Ground Floor

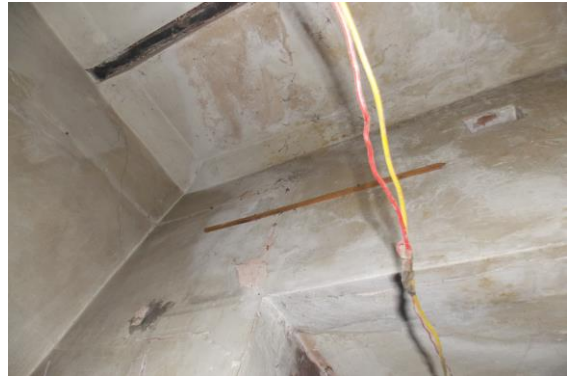
Photo 130

Dampness/Seepage on Wall No. 4 & Roof of Part B of Shop No.271 of Ground Floor

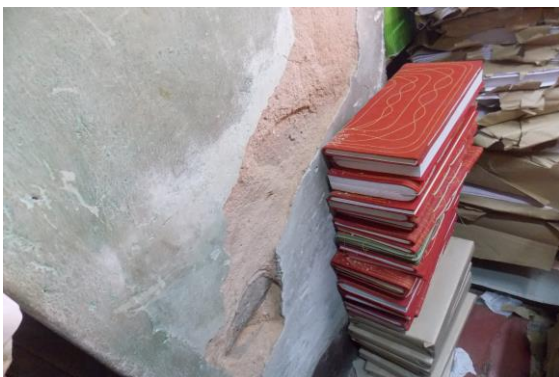
Photo 131

Dampness/Seepage on Roof of Part B of Shop No.271 of Ground Floor

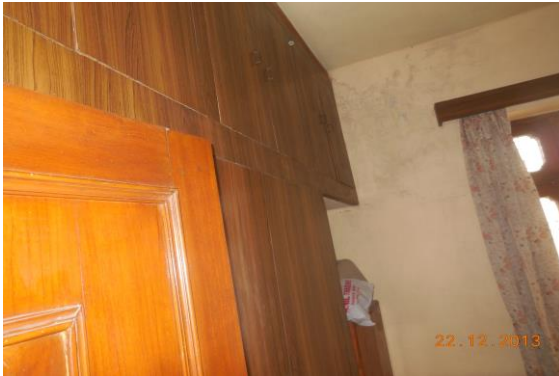
Photo 133

Dampness/Seepage on Roof of Varanda of Shop No.271 of Ground Floor

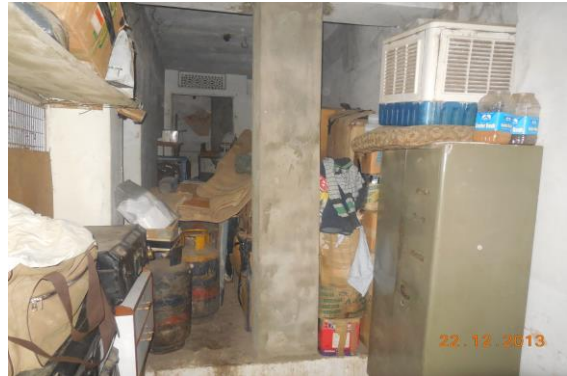
Photo 140

Wall No. 1 & 2 of Store No.2 of House Above Shop No.270 & 271, First Floor Covered With Material

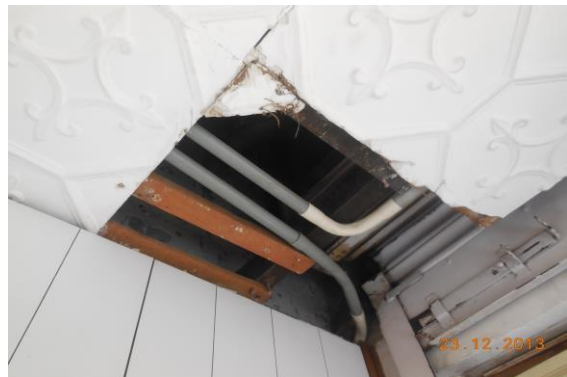
Photo 142

Roof of Hall No. 1 of House NO.846, Second Floor Covered With Falls Ceiling

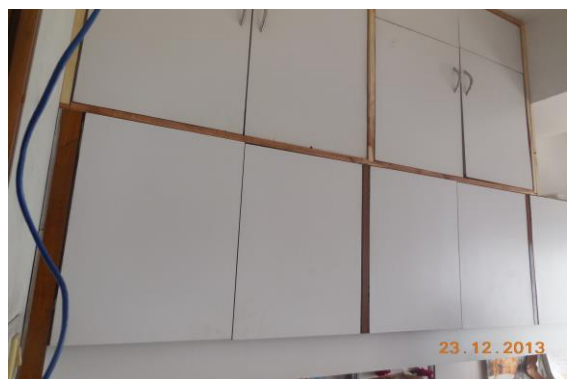
Photo 144

Wall No. 4 of Lobby No.3 of Second Floor Covered With Wooden Work

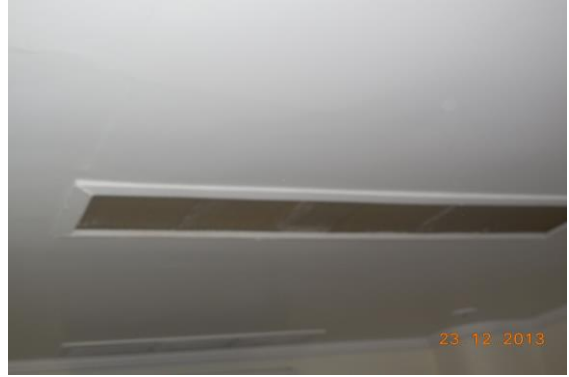
Photo 152

Roof of Passage of House NO.846, Third Floor Covered With Ceiling

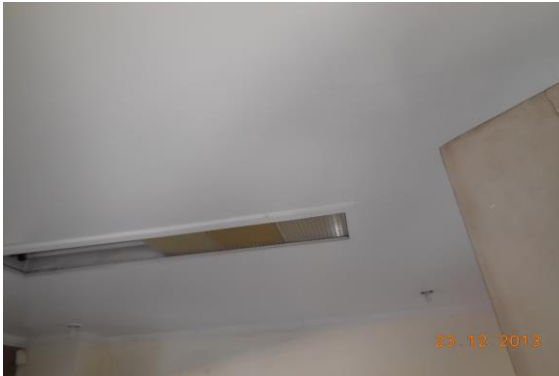
Photo 153

Roof of Room No. 4 of House NO.846, Third Floor Covered With Falls Ceiling

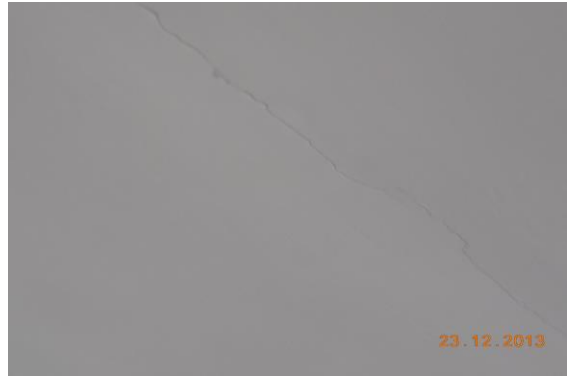
Photo 154

Roof of Hall No. 2 of House NO.846, Third Floor Covered With Falls Ceiling

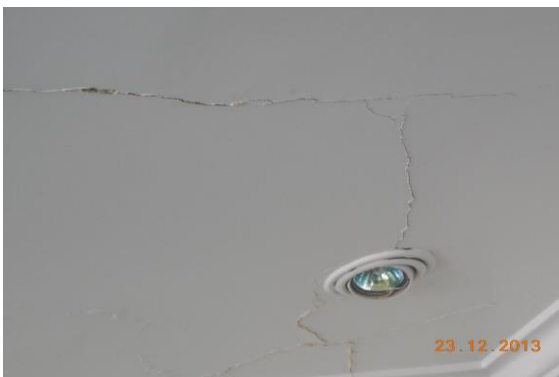
Photo 155

Roof of Hall No. 2 (Part A) of House NO.846, Third Floor Covered With Falls Ceiling

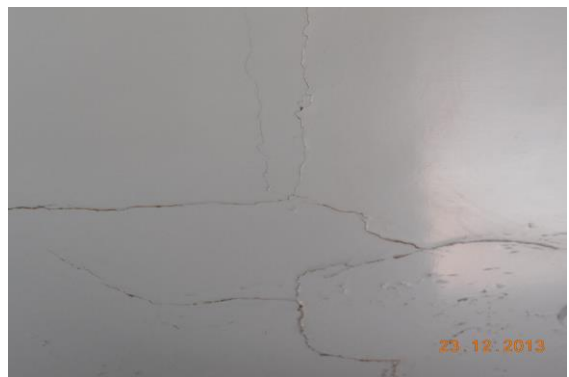
Photo 156

Roof of Hall No. 2 (Part A) of House NO.846, Third Floor Covered With Falls Ceiling

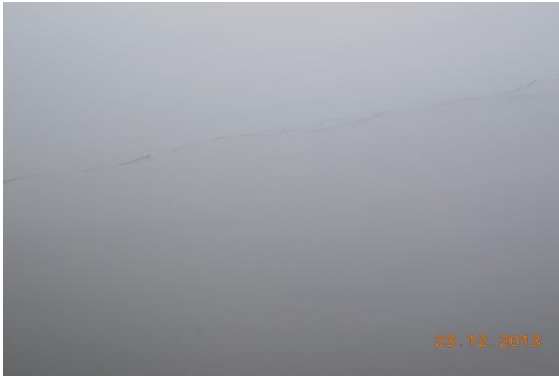
Photo 157

Roof of Hall No. 2 (Part A) of House NO.846, Third Floor Covered With Falls Ceiling

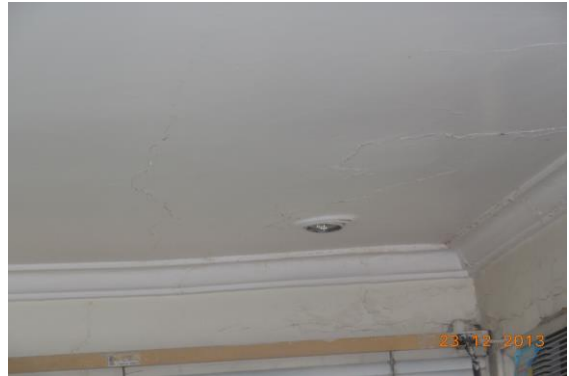
Photo 158

Roof of Hall No. 2 (Part B) of House NO.846, Third Floor Covered With Falls Ceiling

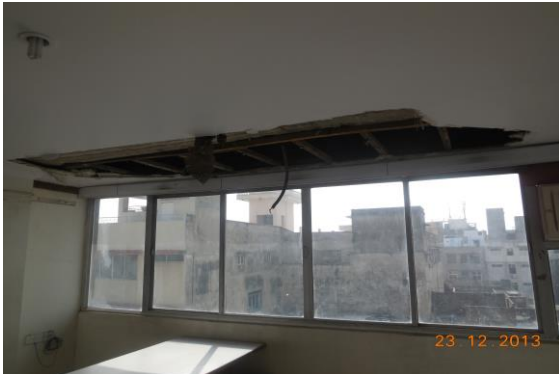
Photo 159

Roof of Hall No. 2 (Part B) of House NO.846, Third Floor Covered With Falls Ceiling

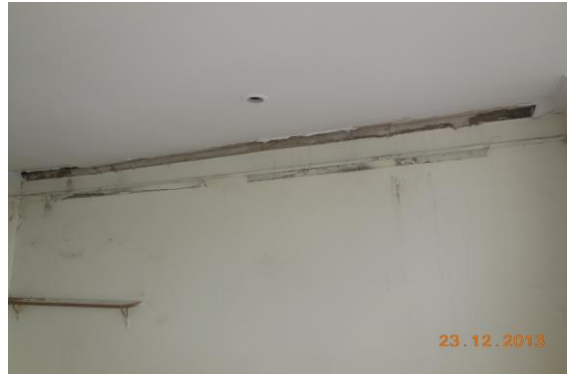
Photo 160

Roof of Hall No. 3 of House NO.846, Third Floor Covered With Falls Ceiling

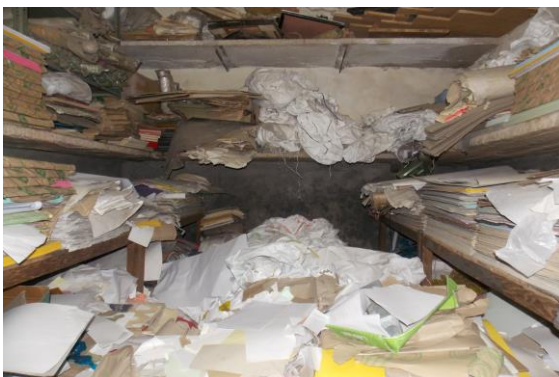
Photo 161

Roof of Hall No. 3 of House NO.846, Third Floor Covered With Falls Ceiling

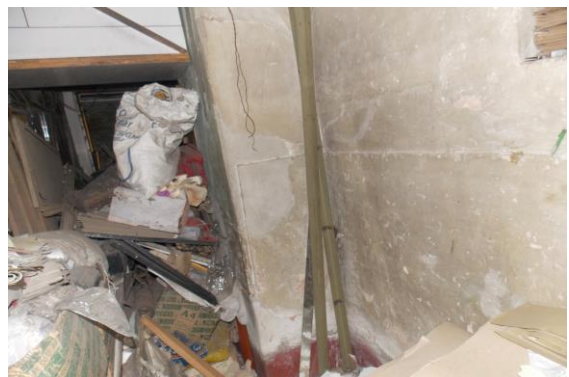
Photo 162

Wall No.1,2 & Floor, of Part B of Shop No.271 of Ground Floor Covered With Material

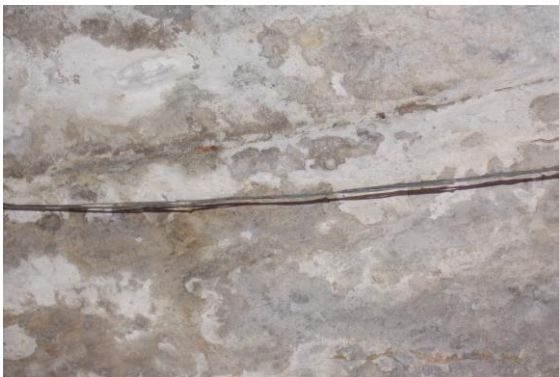
Photo 33
Horizontal Crack on Roof of Varanda of Shop No.266, G/F. Approx. Width = 0.25mm, Approx. Length = 2.3m. Distance from Leftside External Column = Backsidem, Height from Floor = 3.5m.

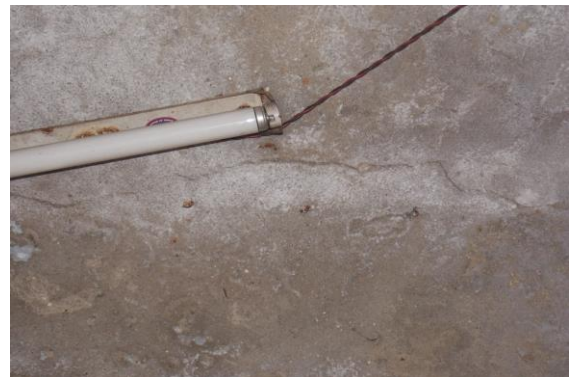
Photo 34
Horizontal Crack on Roof of Varanda of Shop No.265, Ground Floor. Approx. Width = 0.5mm, Approx. Length = 2.5m. Distance from Leftside External Column = 1m, Height from Floor = 3.5m.

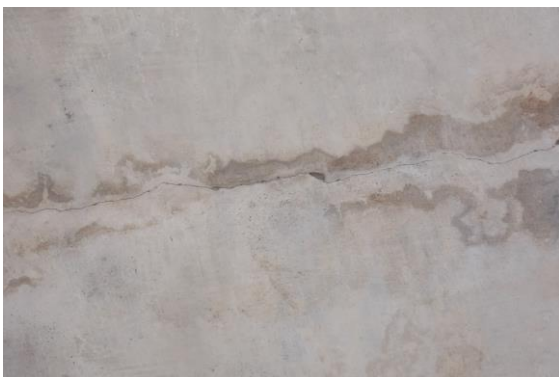
Photo 35
Horizontal Crack on Roof of Varanda of Shop No.264, Ground Floor. Approx. Width = 0.35mm, Approx. Length = 2.5m. Distance from Rightside External Column = 0.5m, Height from Floor = 3.5m.

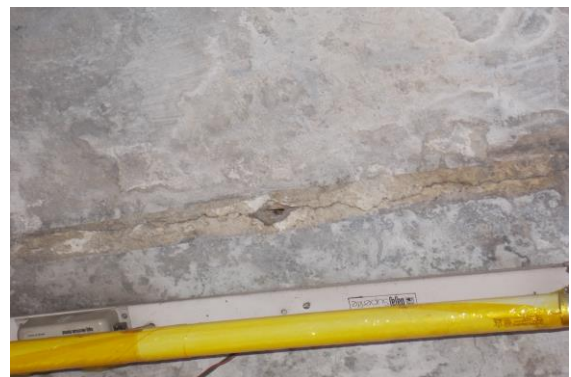
Photo 36
Horizontal Crack on Roof of Varanda of Shop No.264, Ground Floor. Approx. Width = 0.35mm, Approx. Length = 2.5m. Distance from Leftside External Column = 1m, Height from Floor = 3.5m.

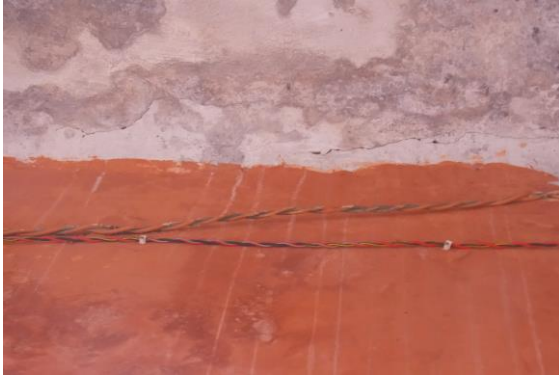
Photo 37

Horizontal Crack on Roof of Varanda of Shop No.264, Ground Floor
Approx. Width = 0.35mm, Approx. Length = 2m. Distance from Leftside
External Column = 0m, Height from Floor = 3.5m.

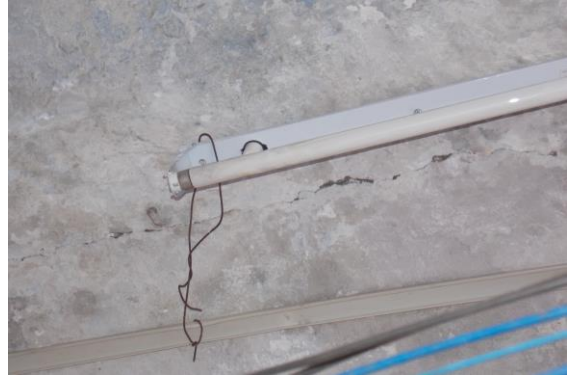
Photo 38

Horizontal Crack on Roof of Varanda of Shop No.261, G/F Approx.
Width = 0.4mm, Approx. Length = 2.5m. Distance from Rightside
External Column = Backsidem, Height from Floor = 3.5m.

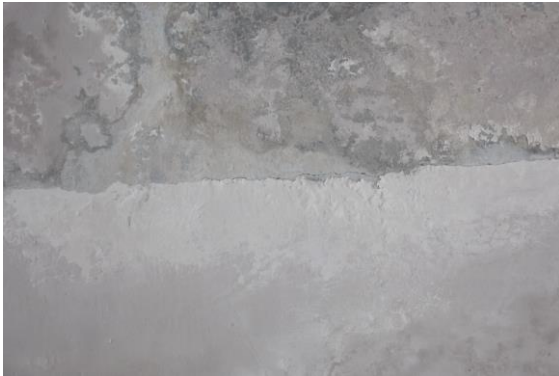
Photo 39

Horizontal Crack on Roof of Varanda of Shop No.261, Ground Floor
Approx. Width = 0.15mm, Approx. Length = 2.5m. Distance from
Leftside External Column = 0.9m, Height from Floor = 3.5m.

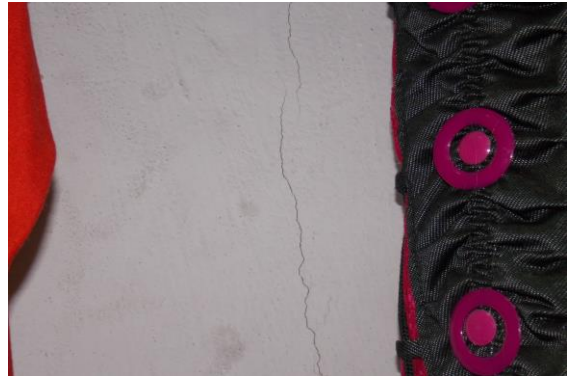
Photo 40

Inclined Crack on Wall No. 4 of Part B of Shop No.260, Ground Floor
Approx. Width = 0.25mm, Approx. Length = 1.25m. Distance from Wall
No.4 = 0.25m, Height from Floor = 1m.

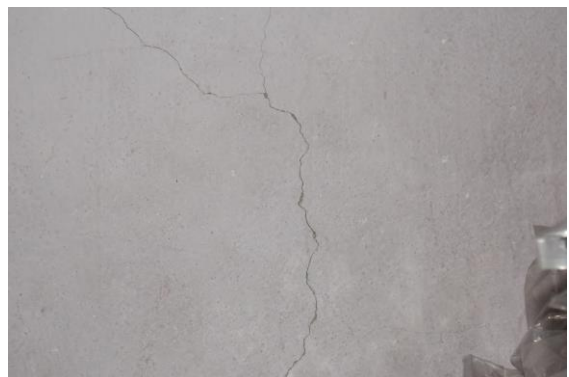
Photo 41

Inclined Crack on Wall No. 2 of Part B of Shop No.260, Ground Floor
Approx. Width = 0.25mm, Approx. Length = 1.6m. Distance from Wall
No.4 = 0.6m, Height from Floor = 0.6m.

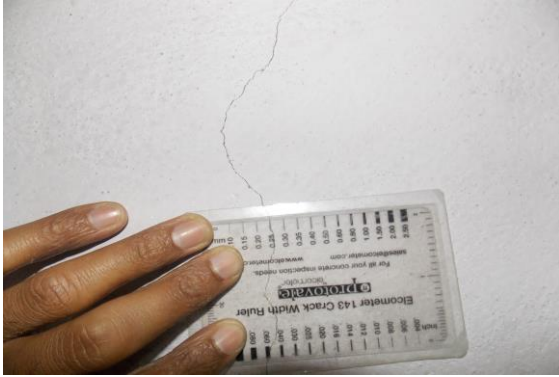
Photo 41A

Inclined Crack on Wall No. 2 of Part B of Shop No.260, Ground Floor
Approx. Width = 0.25mm, Approx. Length = 1.6m. Distance from Wall
No.4 = 0.6m, Height from Floor = 0.6m.

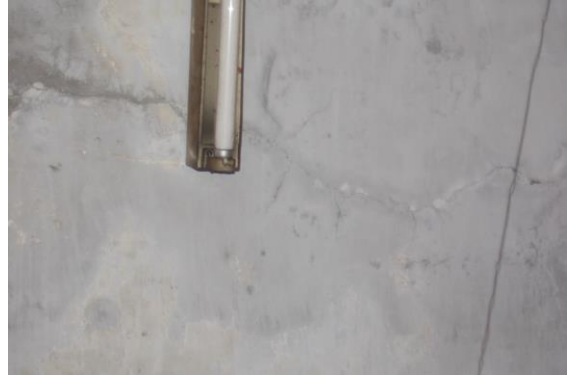
Photo 42

Horizontal Crack on Roof of Varanda of Shop No.260, G/F Approx.
Width = 0.4mm, Approx. Length = 4.5m. Distance from Rightside
External Beam = Backsidem, Height from Floor = 3.5m.

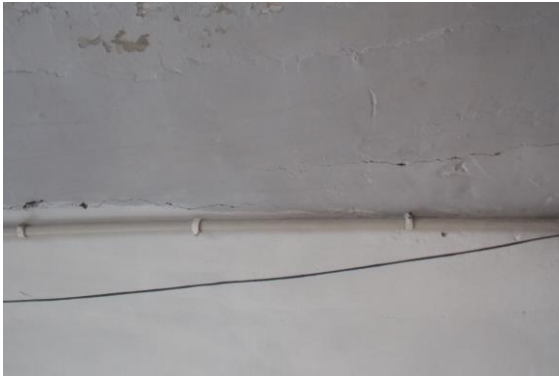
Photo 43

Horizontal Crack on Roof of Varanda of Shop No.259, Ground Floor
Approx. Width = 0.8mm, Approx. Length = 1.5m. Distance from Leftside
External Column = 0m, Height from Floor = 3.5m.

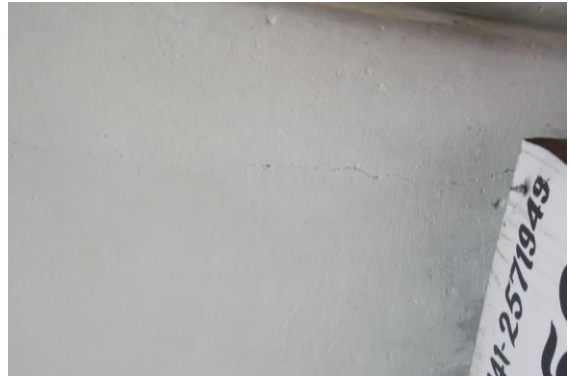
Photo 44

Horizontal Crack on Roof of Varanda of Shop No.259, Ground Floor
Approx. Width = 0.25mm, Approx. Length = 1.5m. Distance from
Leftside External Column = 0m, Height from Floor = 3.5m.

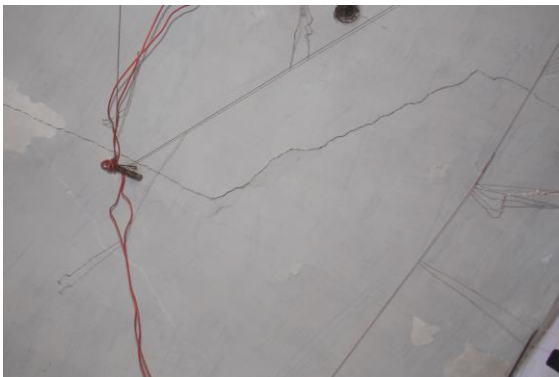
Photo 45

Inclined Crack on Roof of Varanda of Shop No.257, Ground Floor
Approx. Width = 2.5mm, Approx. Length = 3m. Distance from Leftside
External Column = 1.3m, Height from Floor = 3.5m.

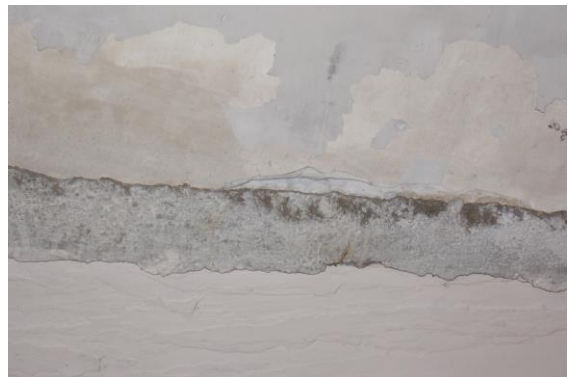
Photo 46

Horizontal Crack on Roof of Varanda of Shop No.257, G/F Approx.
Width = 2.5mm, Approx. Length = 2.5m. Distance from Leftside External
Column = Backsidem, Height from Floor = 3.5m.

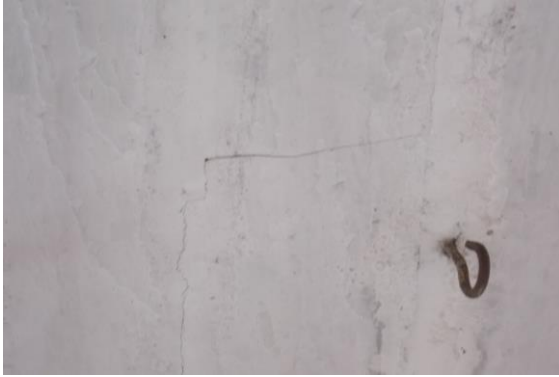
Photo 47

Inclined Crack on Roof of Varanda of Shop No.256, Ground Floor
Approx. Width = 0.5mm, Approx. Length = 2m. Distance from Rightside
External Column = 1.5m, Height from Floor = 3.5m.

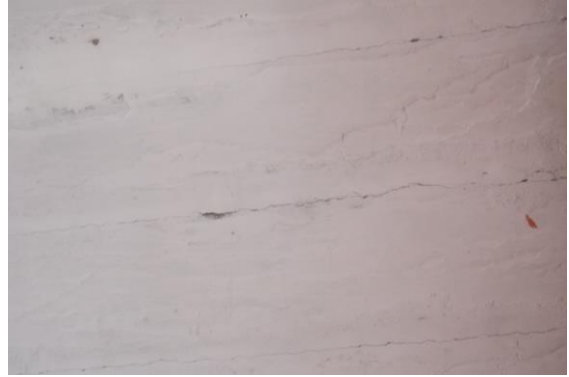
Photo 48

Horizontal Crack on Roof of Varanda of Shop No.256, Ground Floor
Approx. Width = 0.35mm, Approx. Length = 2m. Distance from
Rightside External Column = 0.3m, Height from Floor = 3.5m.

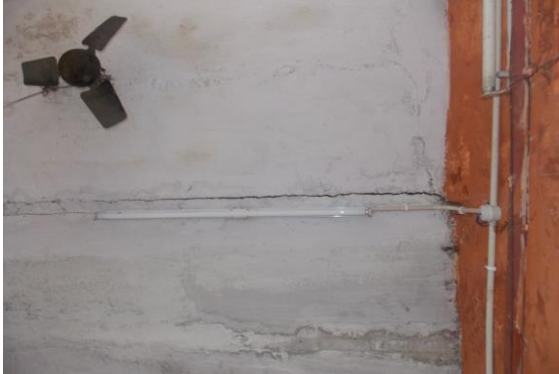
Photo 49

Horizontal Crack on Roof of Varanda of Shop No.255, Ground Floor
Approx. Width = 5mm, Approx. Length = 2.5m. Distance from Rightside
External Column = Backsidem, Height from Floor = 3.5m.

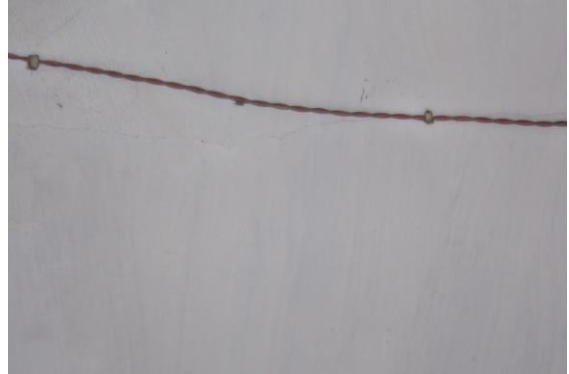
Photo 50

Horizontal Crack on Roof of Varanda of Shop No.270, Ground Floor
Approx. Width = 0.15mm, Approx. Length = 2m. Distance from
Rightside External Column = 1.3m, Height from Floor = 3.5m.

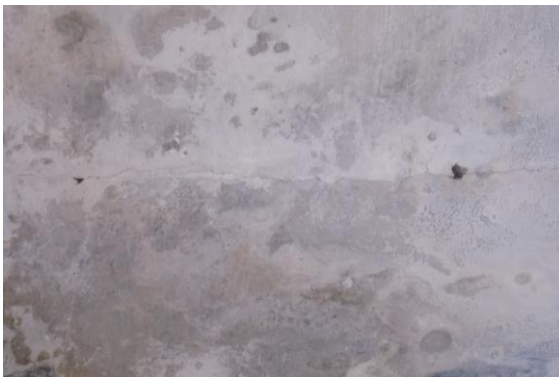
Photo 51

Horizontal Crack on Roof of Varanda of Shop No.270, Ground Floor
Approx. Width = 0.3mm, Approx. Length = 2m. Distance from Leftside
External Column = Backsidem, Height from Floor = 3.5m.

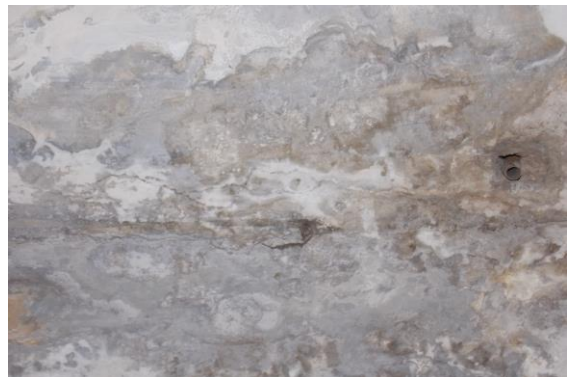
Photo 52

Horizontal Crack on Roof of Varanda, Shop No. 267 Approx. Width =
0.15mm, Approx. Length = 1.3m. Distance from = Backside Right Side
External Columnm, Height from Floor = 3.5m.

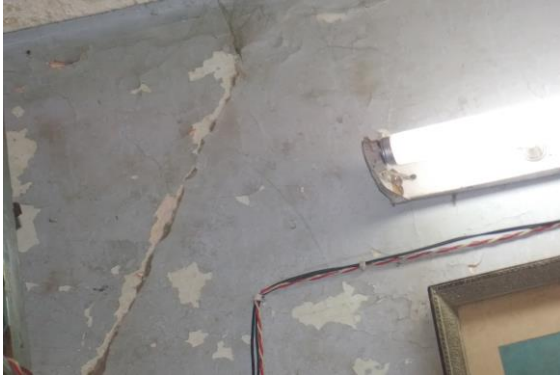
Photo 53

Inclined Crack on Wall No. 4 of Shop, Ground Floor Approx. Width = 1.5mm, Approx. Length = 1.5m. Distance from Wall No.1 = 1m, Height from Floor = 2.1m.

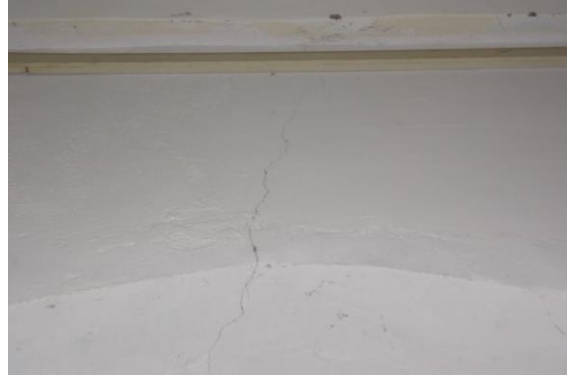
Photo 54

Inclined Crack on Wall No. 3 of Shop No.6, Ground Floor Approx. Width = 0.4mm, Approx. Length = 0.6m. Distance from Wall No.1 = 2.5m, Height from Floor = 2.5m.

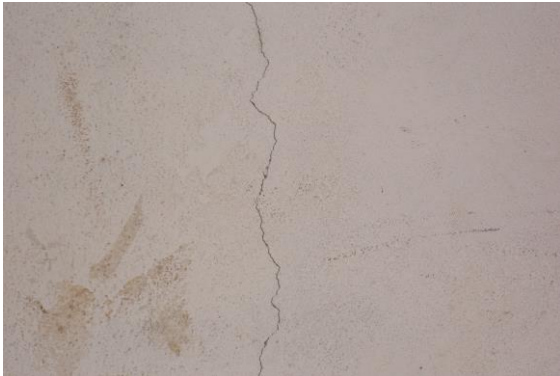
Photo 55

Vertical Crack on Wall No. 1 of Shop No.6, Ground Floor Approx. Width = 0.4mm, Approx. Length = 1.8m. Distance from Wall No.3 = 1.3m, Height from Floor = 0m.

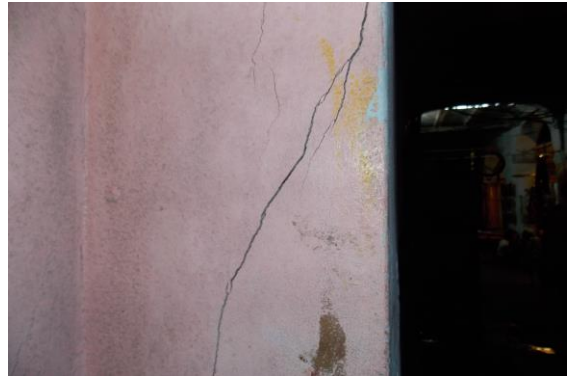
Photo 56

Inclined Crack on Frontside Gate of Shop No.6, Ground Floor Approx. Width = 1.5mm, Approx. Length = 2m. Distance from Wall No.1 = 6m, Height from Floor = 0.6m.

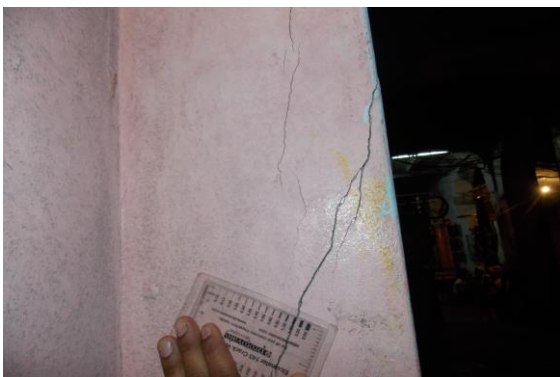
Photo 56A

Inclined Crack on Frontside Gate of Shop No.6, Ground Floor Approx. Width = 1.5mm, Approx. Length = 2m. Distance from Wall No.1 = 6m, Height from Floor = 0.6m.

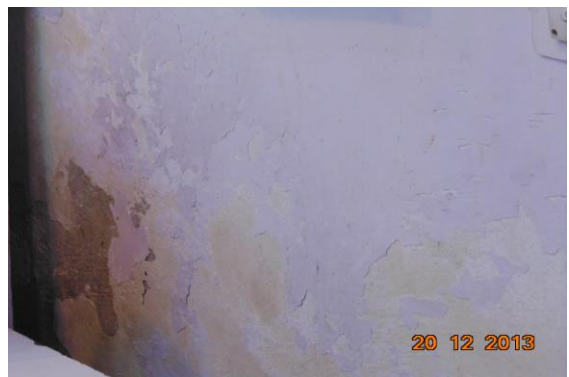
Photo 57

Dampness/Seepage on Wall No. 2 of Gulam Ali Chashme Wale of Ground Floor

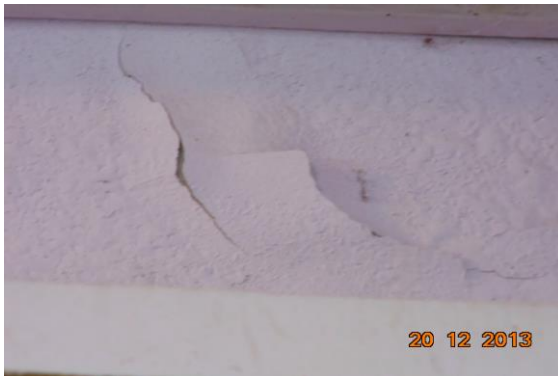
Photo 58

Peeling of Plaster on Wall No. 4 of Gulam Ali Chashme Wale of Ground Floor

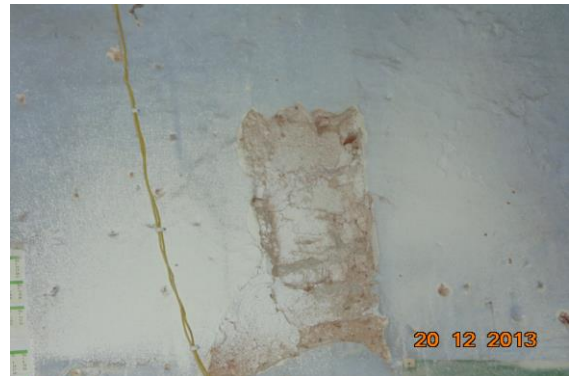
Photo 59

Peeling of Plaster on Wall No. 4 of Kamal Opticals of Ground Floor

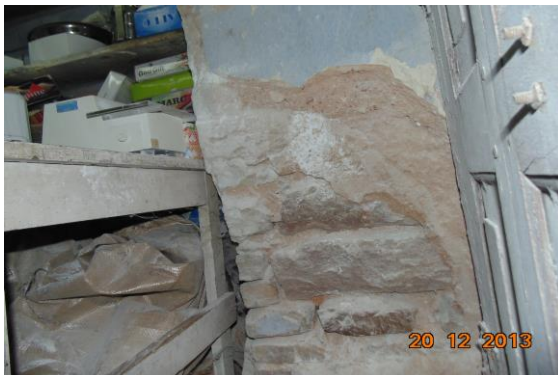
Photo 60

Peeling of Plaster on Wall No. 2 of Kamal Opticals of Ground Floor

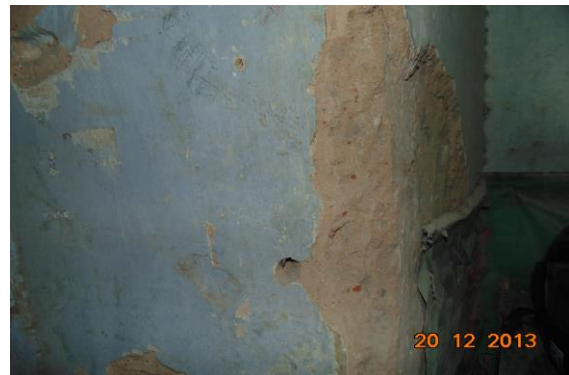
Photo 61

Peeling of Plaster on Wall No. 3 of Kamal Opticals of Ground Floor

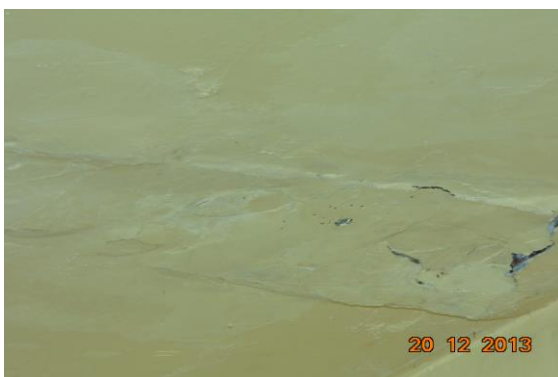
Photo 62

Dampness/Seepage on Roof of ABC Tours & Travels of Ground Floor

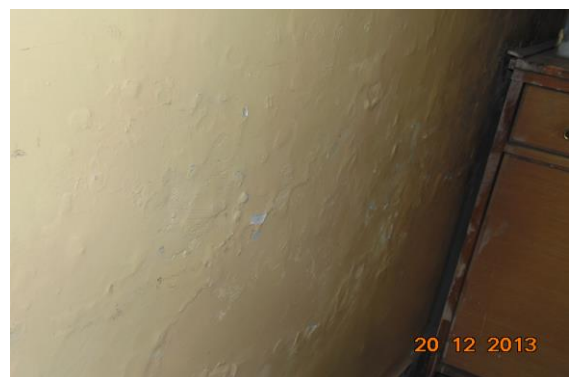
Photo 63

Dampness/Seepage on Wall No. 1 of ABC Tours & Travels of Ground Floor

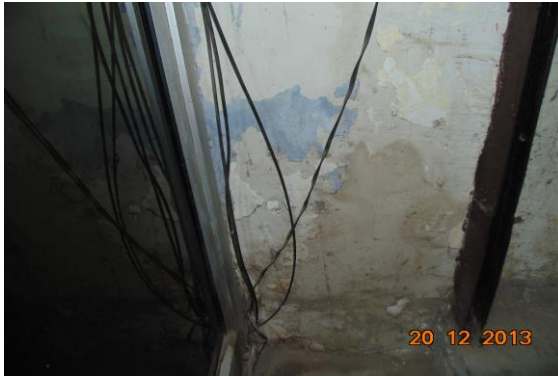
Photo 64

Dampness/Seepage on Wall No. 2 of ABC Tours & Travels of Ground Floor

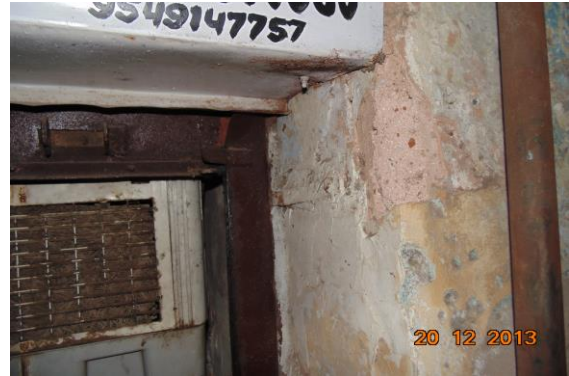
Photo 65

Peeling of Plaster on External Wall of ABC Tours & Travels of Ground Floor

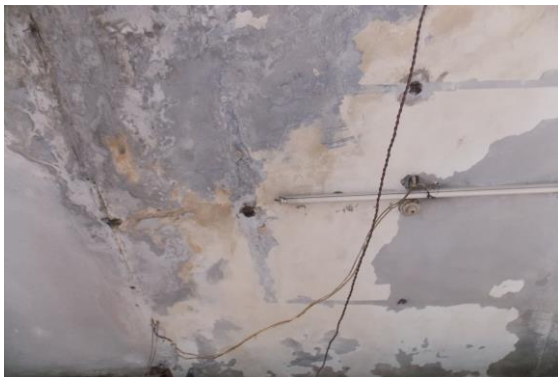
Photo 66

Damaged Portion on Roof of Shop No.268 of Ground Floor
