Pre Building Condition Survey Report

Name and Address of Structure :	Choti Chopar to Badi Chopar (Down Line)
---------------------------------	---

Name of the Project	Contract JMRC-UG1B “Design and Construction of Tunnel between Chandpole and Badi Chouper and reverse line by Shield TBM, Underground Metro Stations at Choti Chouper and Badi Chouper by Cut and Cover Methods on East West Corridor of Jaipur Metro Rail Corporation Limited .”	
Owner :

Pre Building Condition Survey Report Choti Chopar to Badi Chopar (Down Line)

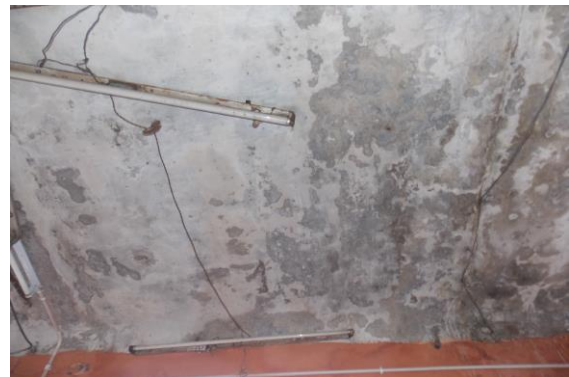
Photo 67

Dampness/Seepage on Roof of Varanda of Shop No.266 of Ground Floor

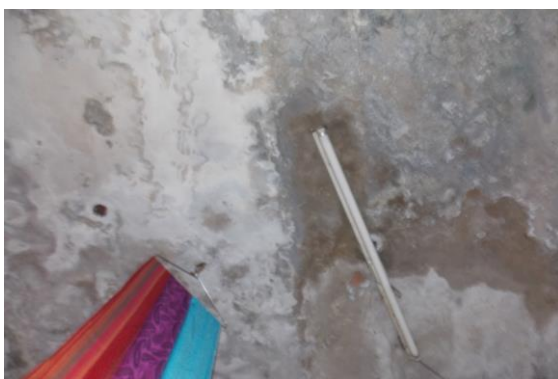
Photo 68

Dampness/Seepage on Roof of Varanda of Shop No.265 of Ground Floor

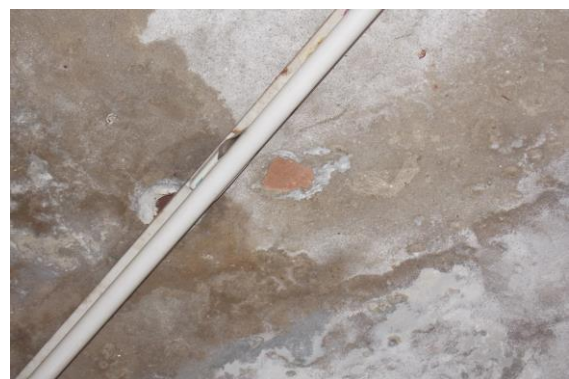
Photo 69

Peeling of Plaster on Roof of Varanda of Shop No.265 of Ground Floor

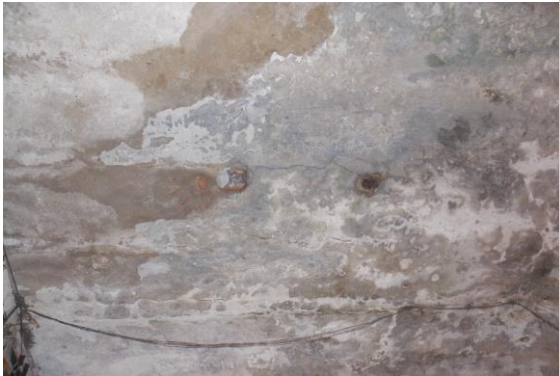
Photo 70

Peeling of Plaster on Roof of Varanda of Shop No.265 of Ground Floor

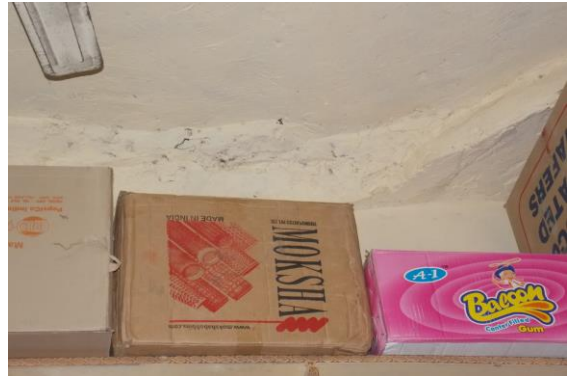
Photo 71

Peeling of Plaster on Roof of Part B of Shop No.264 of Ground Floor

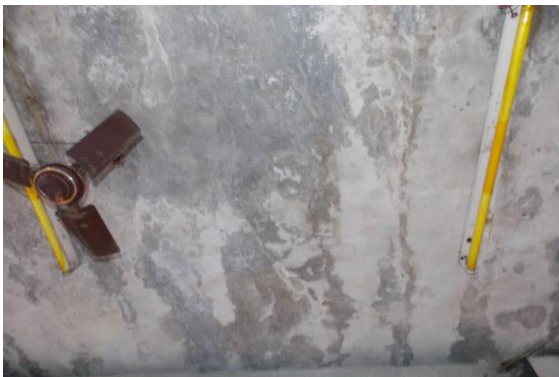
Photo 72

Dampness/Seepage on Roof of Varanda of Shop No.264 of Ground Floor

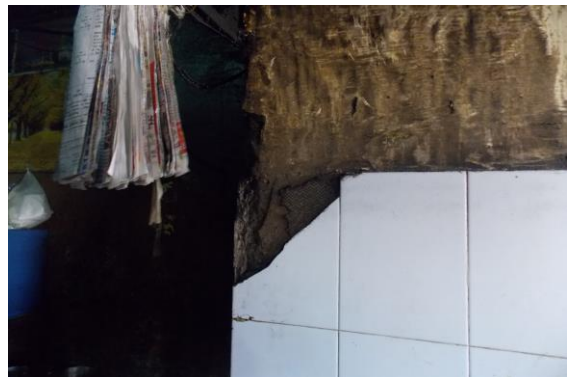
Photo 73

Peeling of Plaster on Wall No. 2 of Shop No.262 of Ground Floor

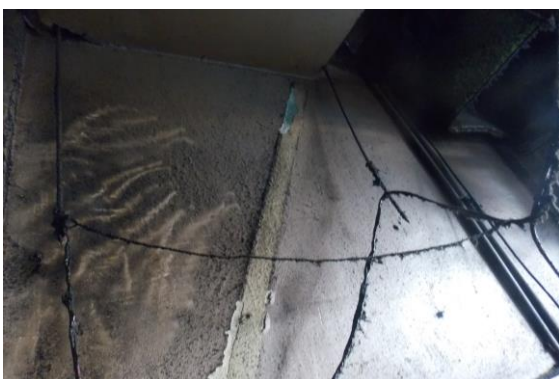
Photo 74

Peeling of Plaster on Wall No. 2 of Shop No.262 of Ground Floor

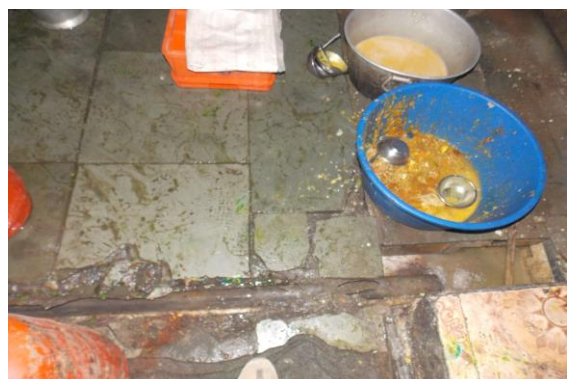
Photo 75

Damaged Portion on Floor of Shop No.262 of Ground Floor

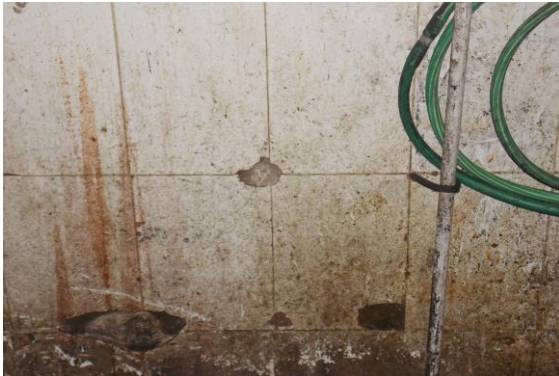
Photo 76

Peeling of Plaster on Wall No. 2 of Shop No.262 of Ground Floor

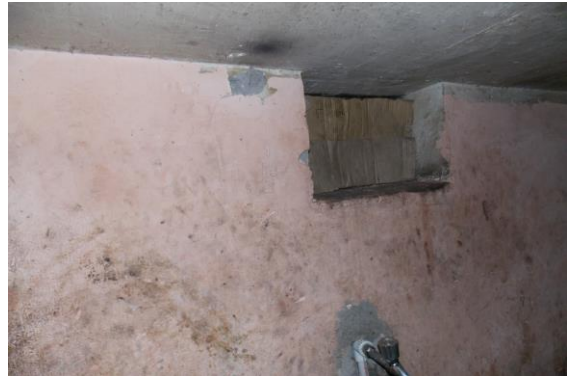
Photo 77

Peeling of Plaster on Wall No. 5 of Shop No.262 of Ground Floor

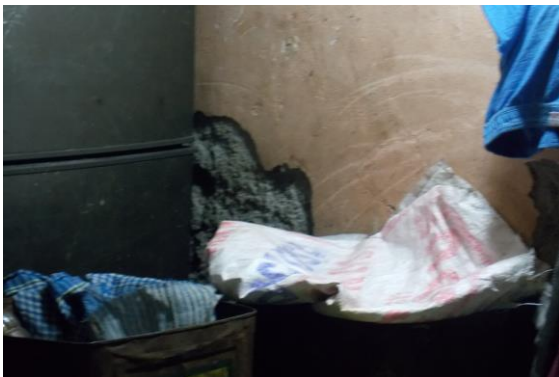
Photo 78

Peeling of Plaster on Wall No. 4 of Shop No.262 of Ground Floor

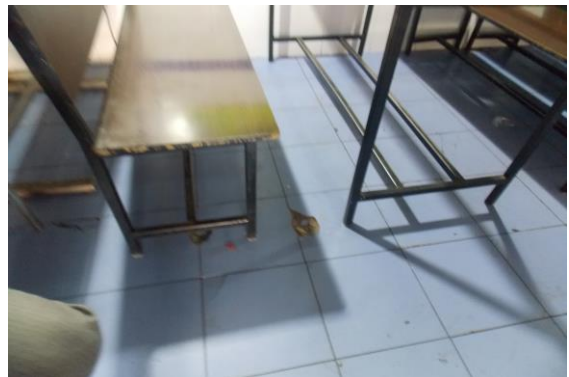
Photo 79

Damaged Portion on Floor of Shop No.262 of Ground Floor

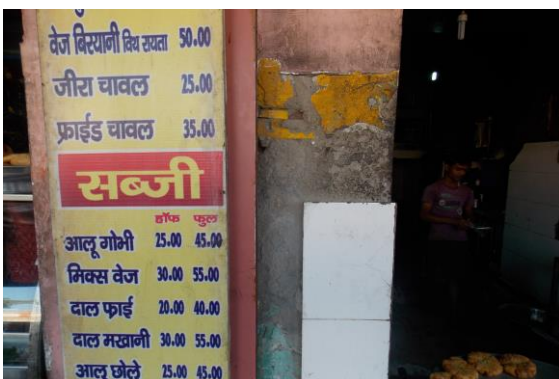
Photo 80

Peeling of Plaster on External Wall of Varanda of Shop No.262 of Ground Floor

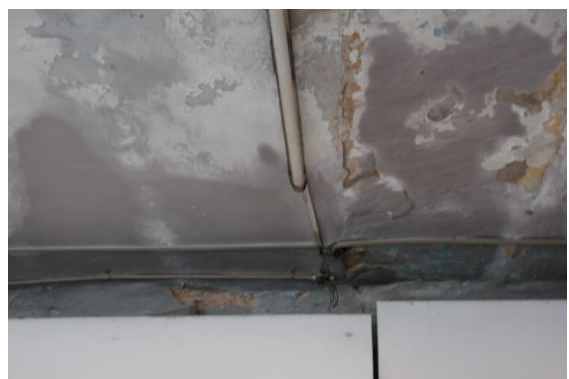
Photo 81

Dampness/Seepage on Roof of Varanda of Shop No.262 of Ground Floor

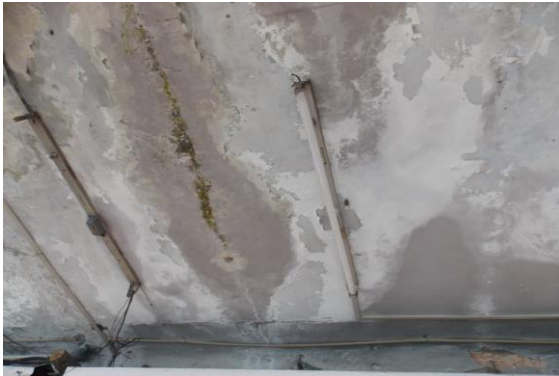
Photo 82

Dampness/Seepage on Roof of Varanda of Shop No.262 of Ground Floor

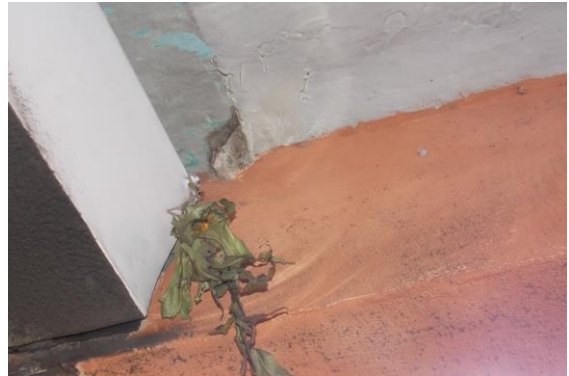
Photo 83

Damaged Portion on Right side Beam of Varanda of Shop No.262 of Ground Floor

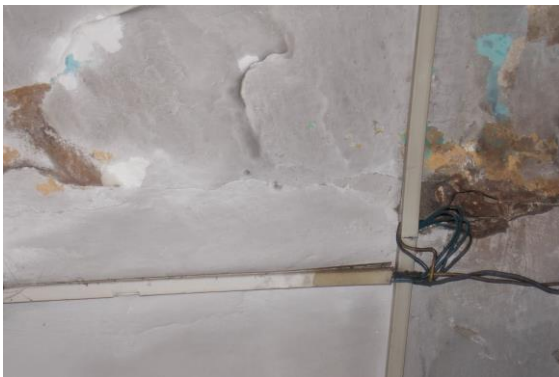
Photo 84

Damaged Portion on Roof of Varanda of Shop No.262 of Ground Floor

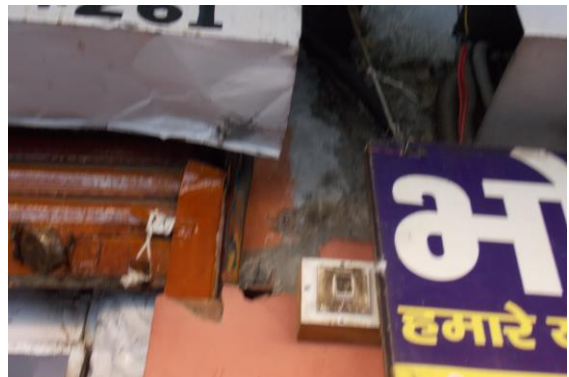
Photo 85

Damaged Portion on Rightside External Beam of Varanda of Shop No.261 of Ground Floor

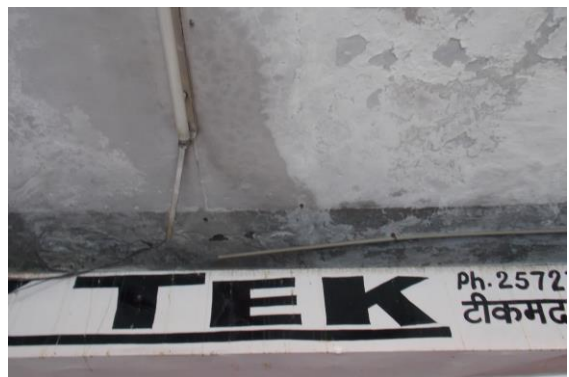
Photo 87

Dampness/Seepage on Roof of Varanda of Shop No.261 of Ground Floor

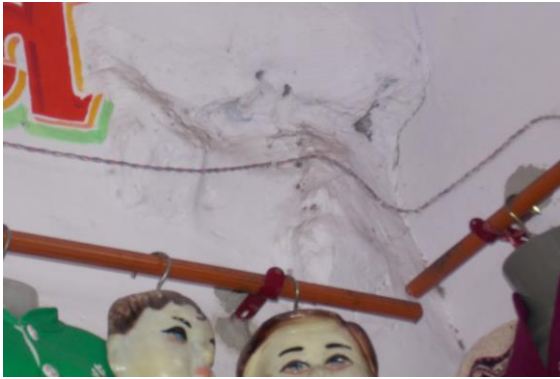
Photo 88

Peeling of Plaster on Roof of Part A of Shop No.260 of Ground Floor

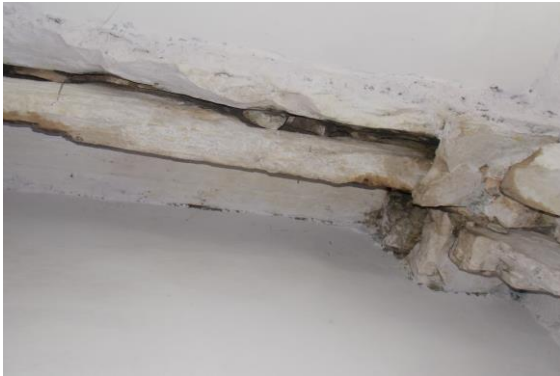
Photo 90

Damaged Portion on Roof of Part B of Shop No.260 of Ground Floor

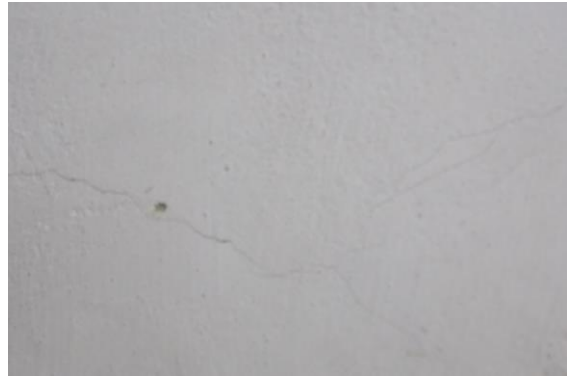
Photo 91

Plaster Crack on Wall No. 2 of Part B of Shop No.260 of Ground Floor

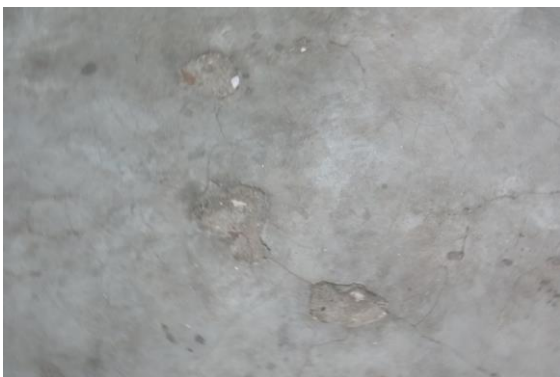
Photo 92

Damaged Portion on Floor of Part B of Shop No.260 of Ground Floor

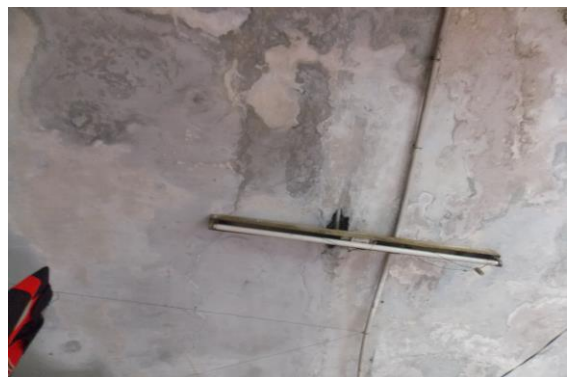
Photo 93

Dampness/Seepage on Roof of Varanda of Shop No.260 of Ground Floor

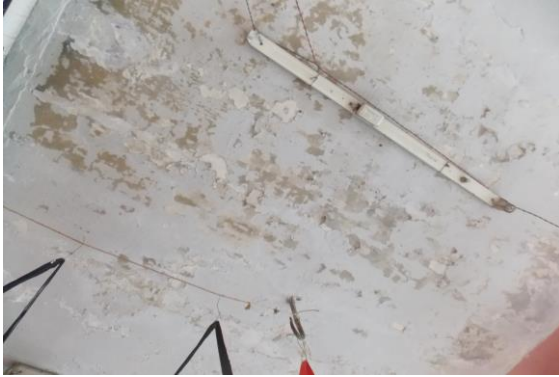
Photo 94

Dampness/Seepage on Roof of Varanda of Shop No.259 of Ground Floor

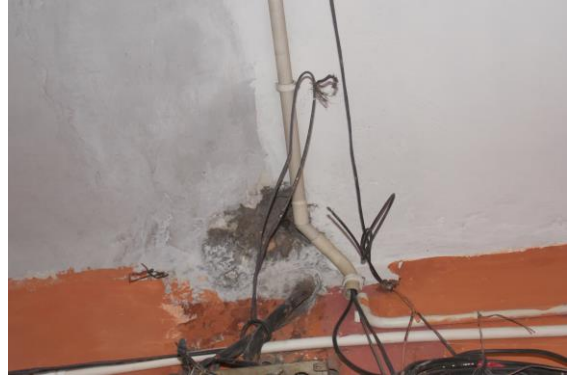
Photo 95

Damaged Portion on Roof of Varanda of Shop No.259 of Ground Floor

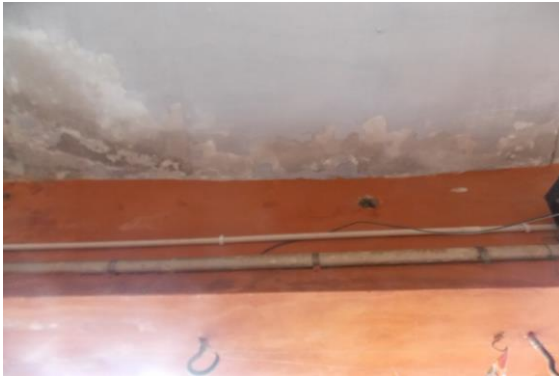
Photo 96

Peeling of Plaster on Roof of Varanda of Shop No.257 of Ground Floor

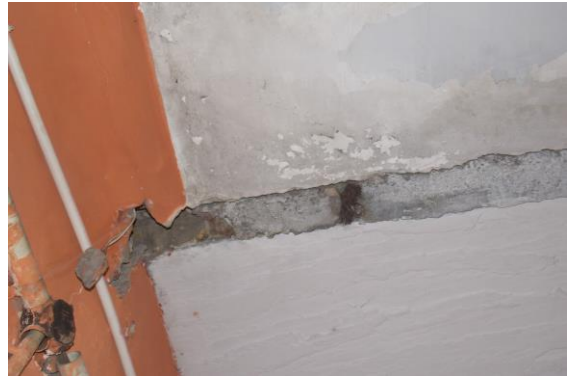
Photo 97

Damaged Portion on Roof of Varanda of Shop No.257 of Ground Floor

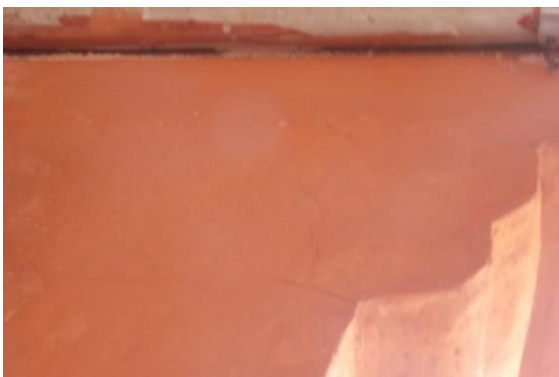
Photo 98

Peeling of Plaster on Rightside External Column of Varanda of Shop No.256 of Ground Floor

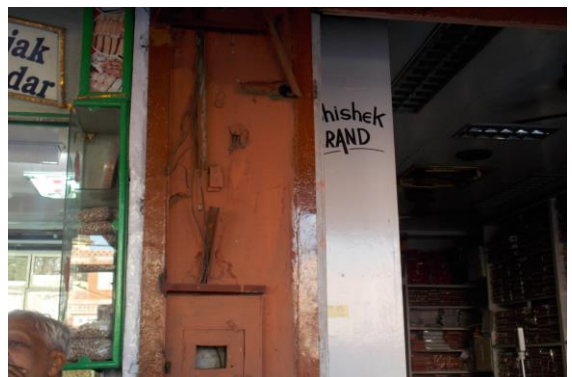
Photo 99

Damaged Portion on Internal Right Side Column of Varanda of Shop No.255 of Ground Floor

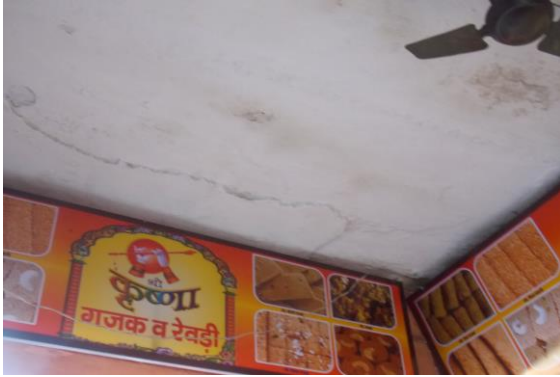
Photo 100

Peeling of Plaster on Roof of Varanda of Shop No.255 of Ground Floor

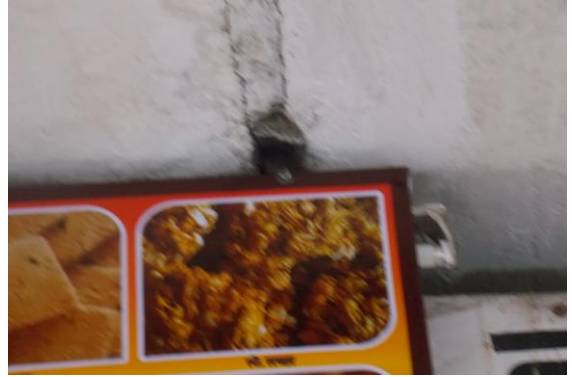
Photo 101

Damaged Portion on Roof of Varanda of Shop No.255 of Ground Floor

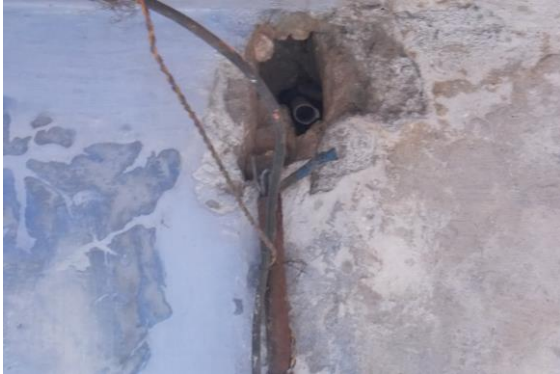
Photo 102

Damaged Portion on Roof of Varanda of Shop No.270 of Ground Floor

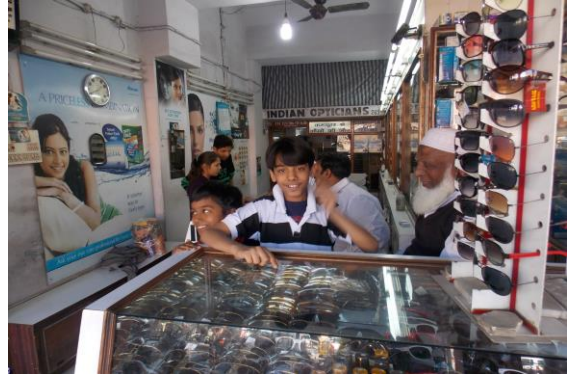
Photo 103

Dampness/Seepage on Roof of Varanda of Shop No.269 of Ground Floor

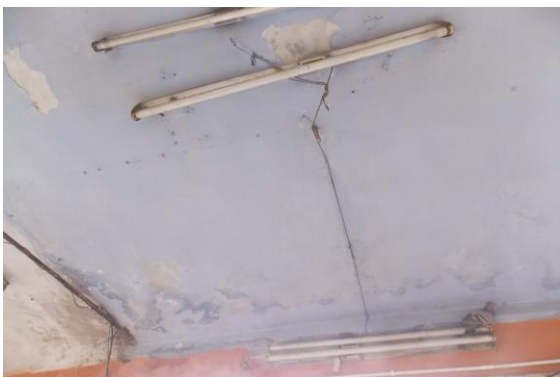
Photo 104

Damaged Portion on Roof of Varanda of Shop No.269 of Ground Floor

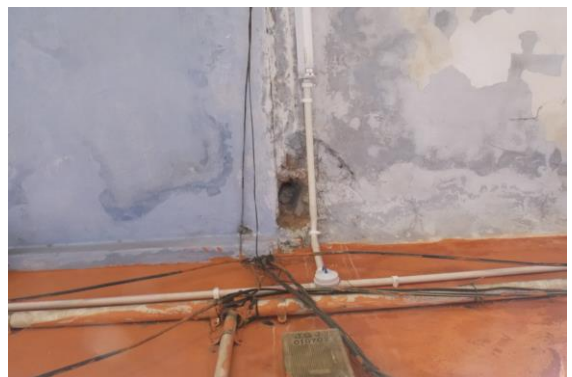
Photo 105

Damaged Portion on Roof of Varanda of Shop No.269 of Ground Floor

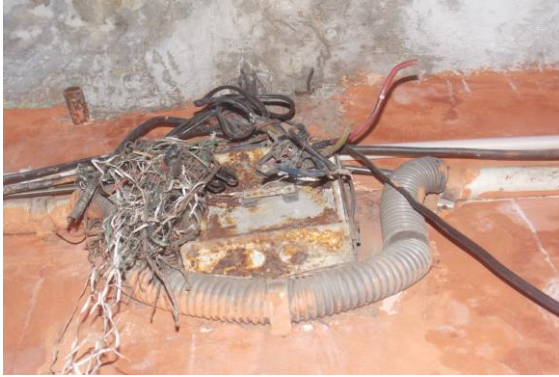
Photo 106
Dampness/Seepage on Roof of Varanda of Shop No. 267

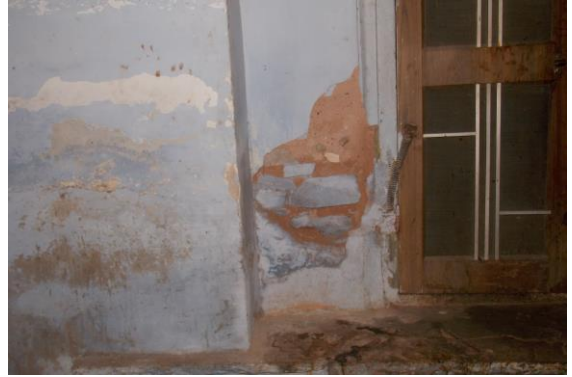
Photo 107
Damaged Portion on Leftside Gate of Shop of Ground Floor

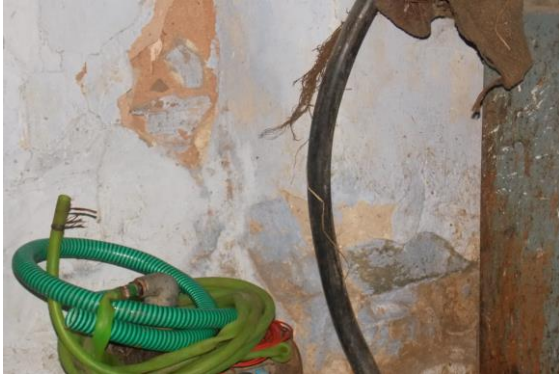
Photo 108
Damaged Portion on Leftside Gate of Shop of Ground Floor

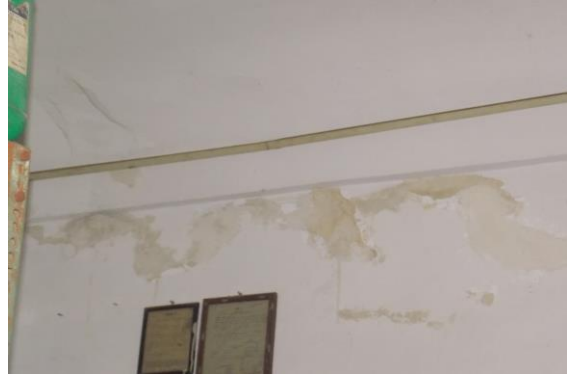
Photo 109
Dampness/Seepage on Wall No. 4 of Shop No.6 of Ground Floor

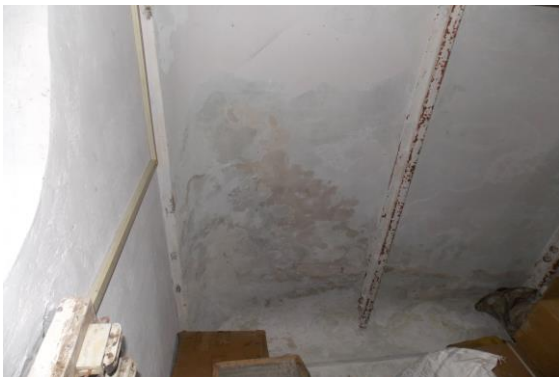
Photo 110
Dampness/Seepage on Roof of Shop No.6 of Ground Floor

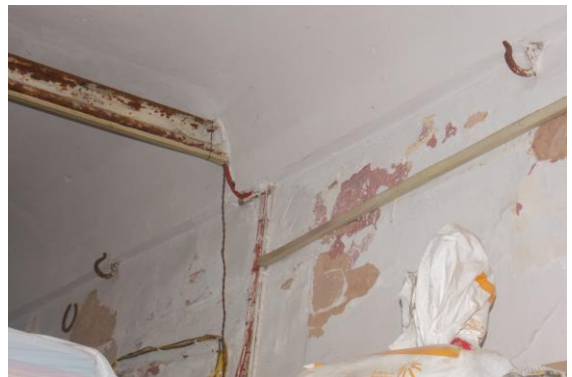
Photo 111
Peeling of Plaster on Wall No. 3 of Shop No.6 of Ground Floor

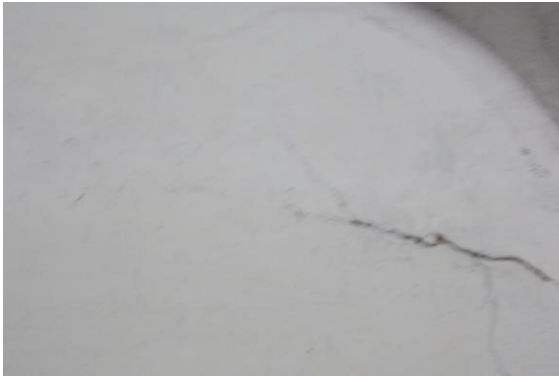
Photo 112
Peeling of Plaster on Wall No. 3 of Shop No.6 of Ground Floor

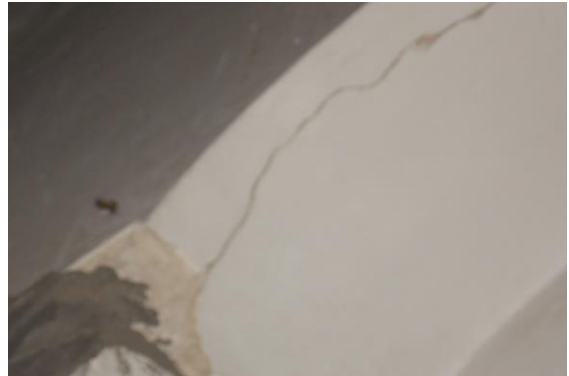
Photo 113
Plaster Crack on Frontside Wall of Shop No.6 of Ground Floor

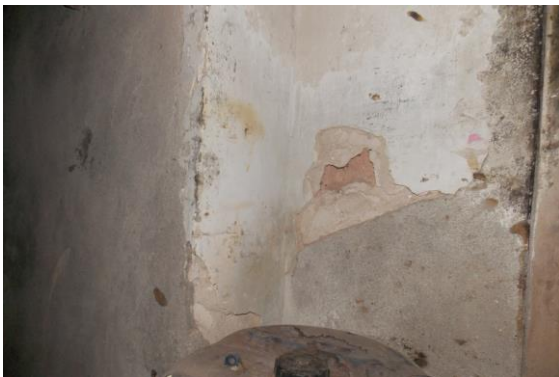
Photo 114
Peeling of Plaster on Frontside Wall of Shop No.6 of Ground Floor

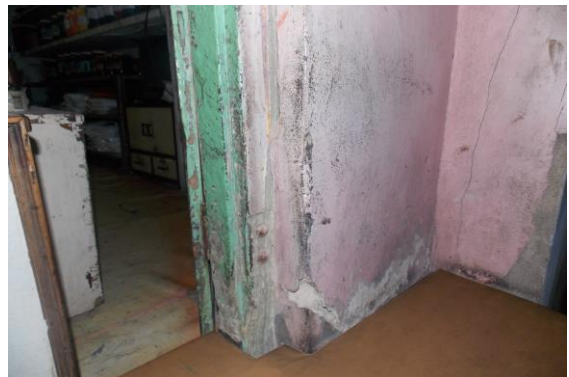
Photo 115
Damaged Portion on Frontside Gate of Shop No.6 of Ground Floor

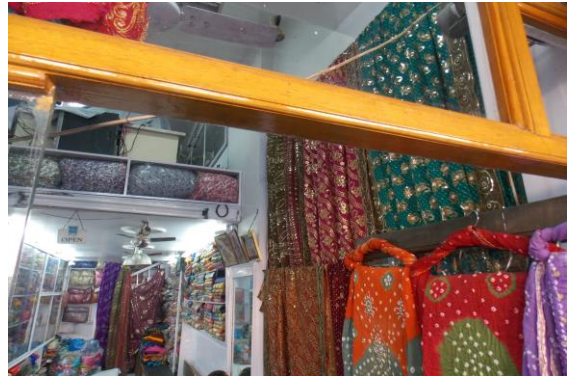
Photo 132

Wall No. 1, 4 & Roof of Shop No.266 of Ground Floor Covered With Material

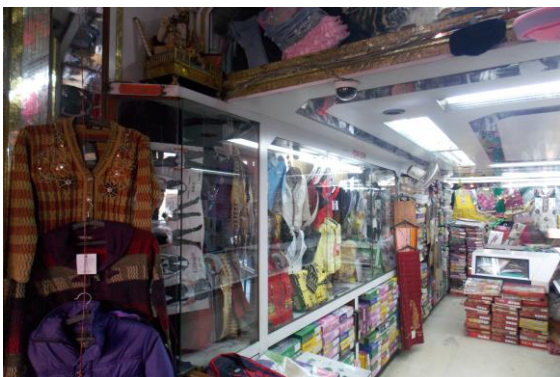
Photo 133

Wall No. 2 & 4 of Shop No.266 of Ground Floor Covered With Material

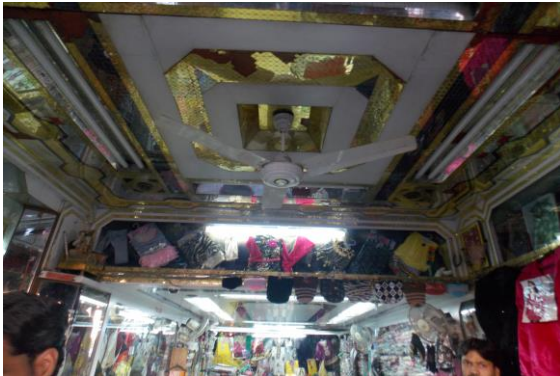
Photo 135

Wall No. 2 & 4 of Shop No.265 of Ground Floor Covered With Material & Wooden Work

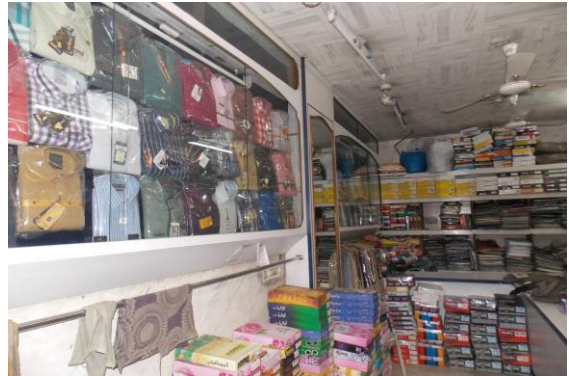
Photo 136
Roof of Shop No. 265 of Ground Floor Covered With Falls Ceiling

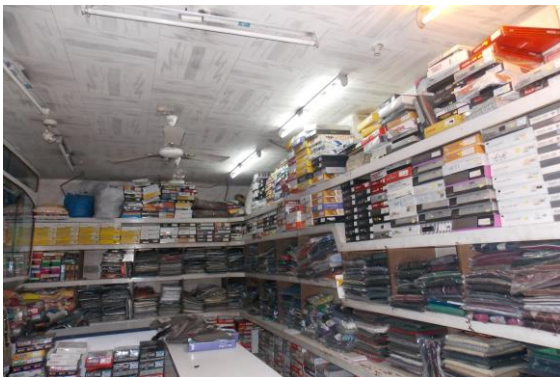
Photo 137
Wall No. 1 & 4 of Shop No. 265 of Basement

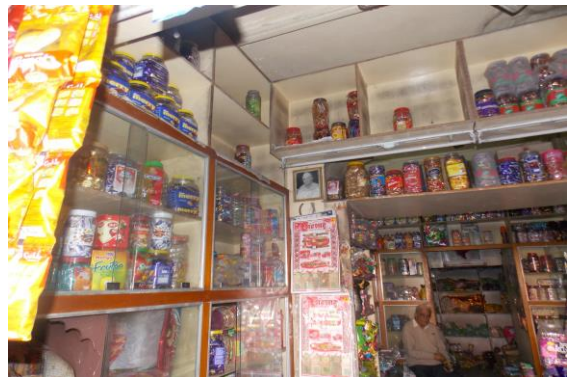
Photo 138
Wall No. 2 & 4 of Shop No. 265 of Basement Covered With Material

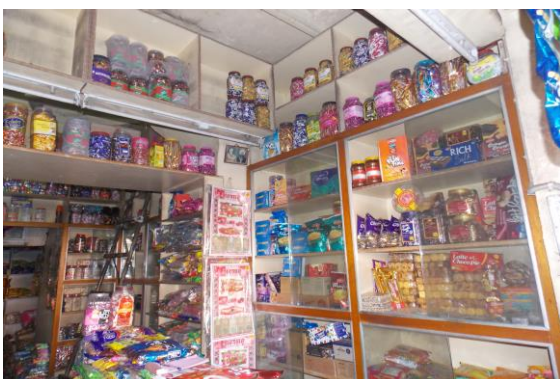
Photo 139
Wall No. 1 & 4 of Part A of Shop No. 264 of Ground Floor Covered With Material

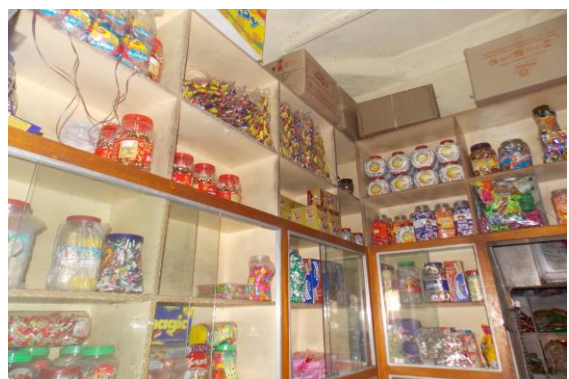
Photo 140
Wall No. 2 & 4 of Part A of Shop No. 264 of Ground Floor Covered With Material

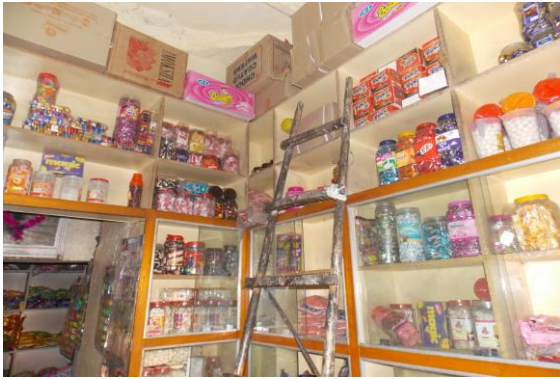
Photo 141
Wall No. 1 & 4 of Part B of Shop No. 264 of Ground Floor Covered With Material

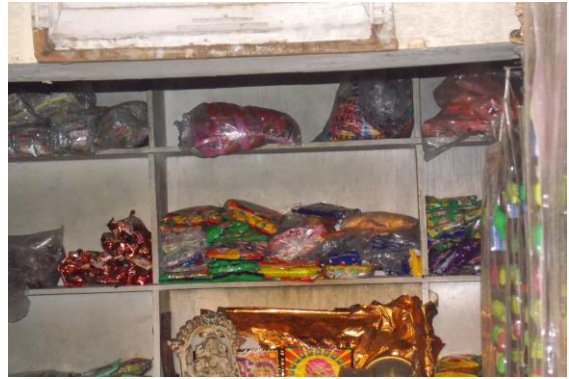
Photo 142

Wall No. 2 & 4 of Part B of Shop No.264 of Ground Floor Covered With Material

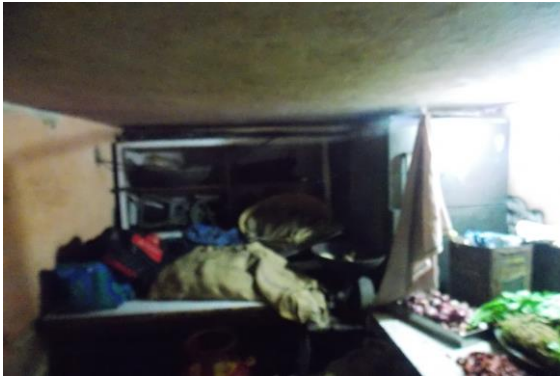
Photo 143

Wall No. 1, 2 & 4 of Part C of Shop No.264 of Ground Floor Covered With Material

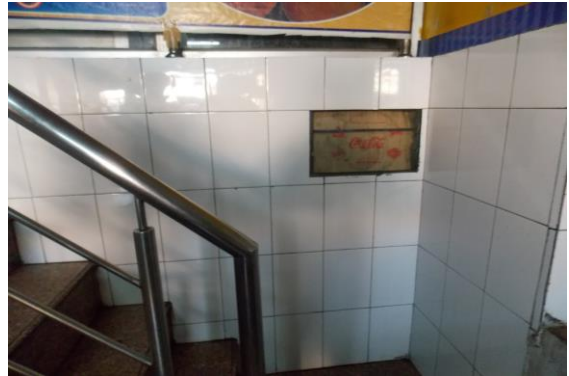
Photo 144

Wall No. 6 of Shop No.262 of Ground Floor Covered With Wooden work & Material

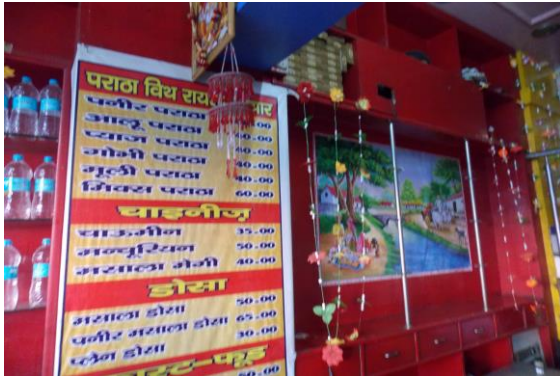
Photo 147

Wall No. 2 of Shop No.262 of Upper Ground Floor Covered With Wooden work & Material

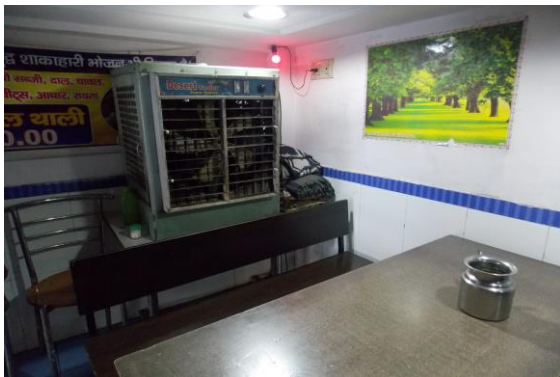
Photo 149

Roof of Shop No.262 of Upper Ground Floor Covered With Wooden Ceiling

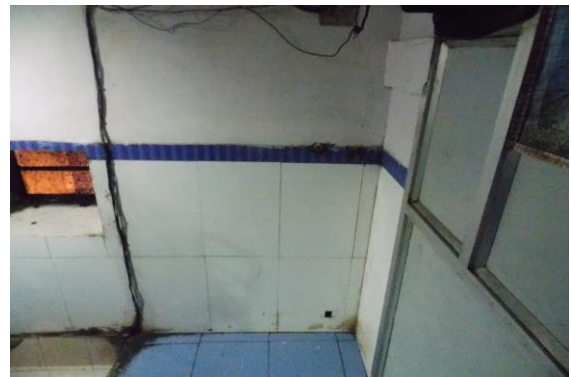
Photo 150

Wall No. 1 & 4 of Shop No.262 of Ground Floor Covered With Tile

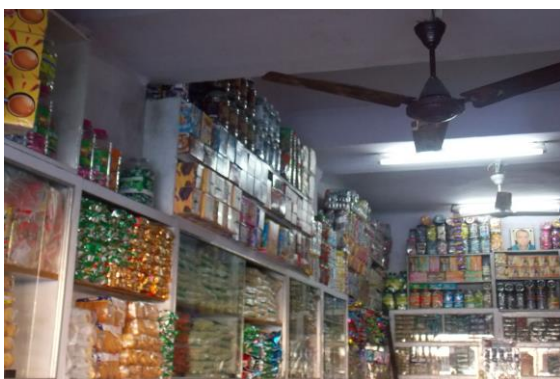
Photo 151

Wall No. 2 of Shop No.262 of Ground Floor Half Covered With Tile

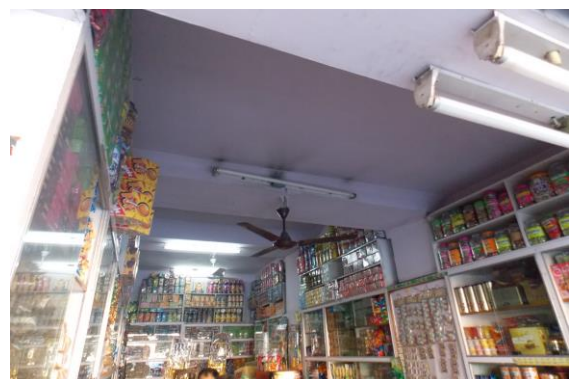
Photo 152

Wall No. 1 & 4 of Shop No.261 of Ground Floor Covered With Material

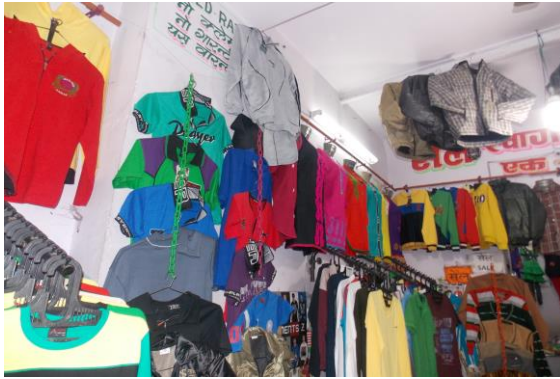
Photo 153

Wall No. 2 & 4 of Shop No.261 of Ground Floor Covered With Material

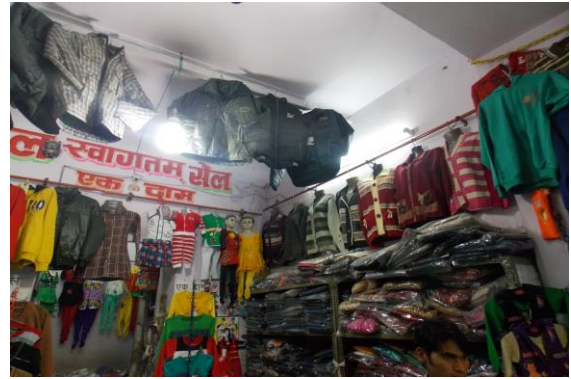
Photo 154

Wall No. 1 & 4 of Part A of Shop No.260 of Ground Floor

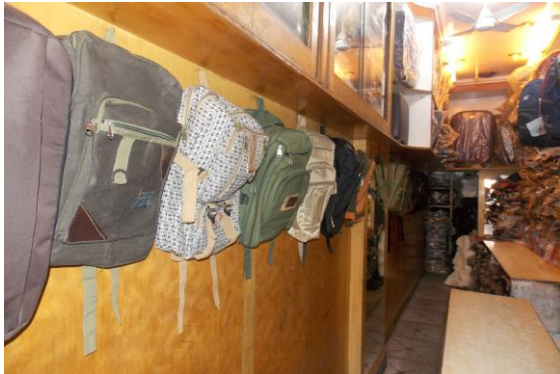
Photo 155

Wall No. 2 & 4 of Part A of Shop No.260 of Ground Floor

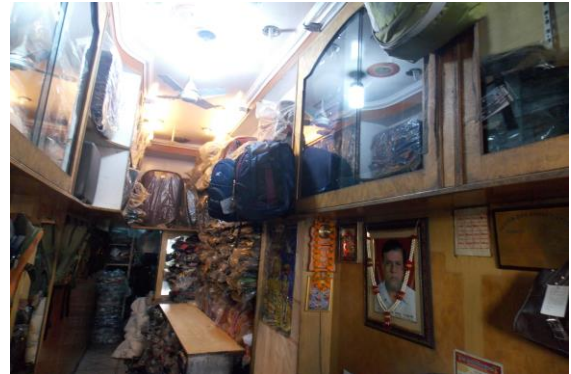
Photo 156

Wall No. 1 of Part A of Shop No.259 A of Ground Floor Covered With wooden Work

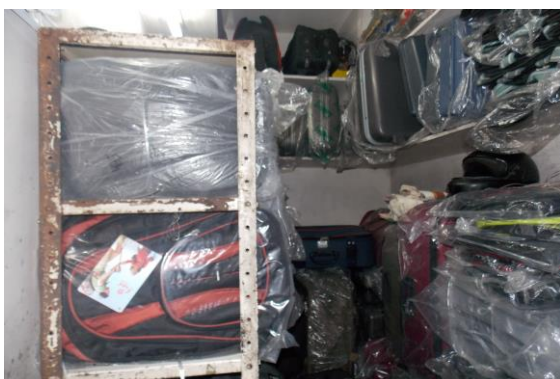
Photo 157

Wall No. 2 & 4 of Part A of Shop No.259 A of Ground Floor Covered With wooden Work

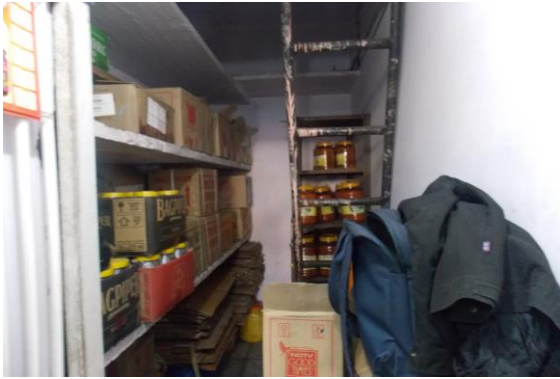
Photo 159

All Walls of Part A of Shop No.259 of Ground Floor Covered With Material

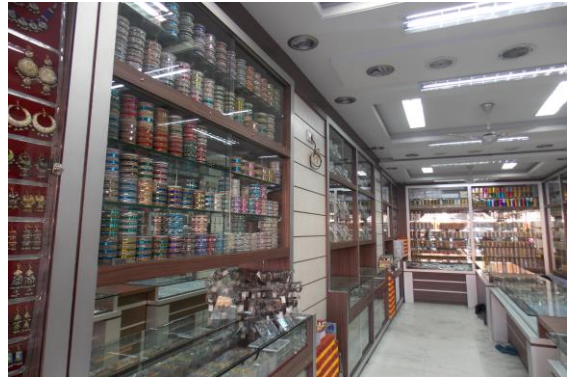
Photo 160

All Walls of Part B of Shop No.259 of Ground Floor Covered With Material

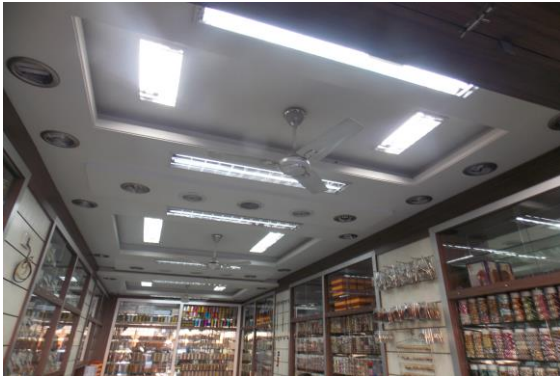
Photo 161

Wall No. 1 & 4 of Shop No.258 of Ground Floor Covered With Material

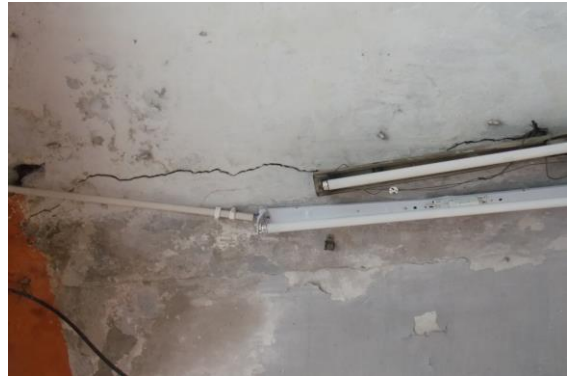
Photo 162

Wall No. 2, 4 & Roof of Shop No.258 of Ground Floor Covered With Material & Roof Ceiling work

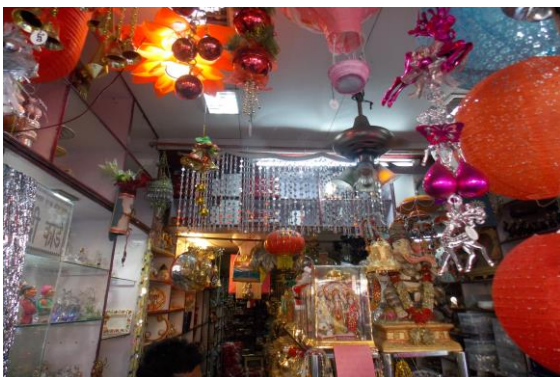
Photo 163

Roof of Varanda of Shop No.258 of Ground Floor

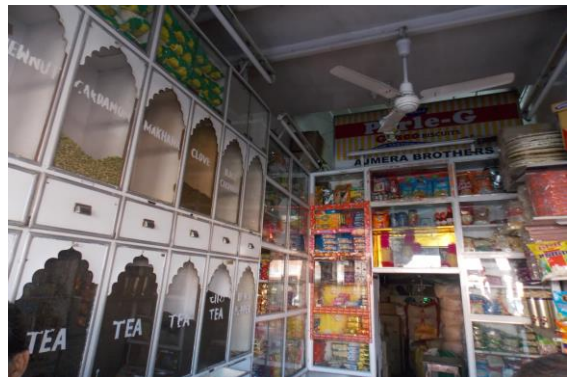
Photo 168

All Walls of Shop No.255 of Ground Floor Covered With Material & Wooden Ceiling

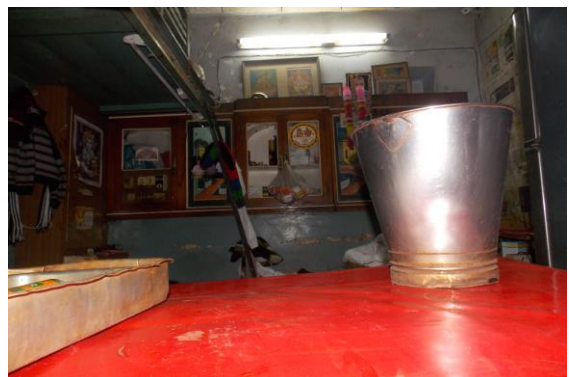
Photo 176

All Walls of Shop No.5 of Ground Floor Covered With Material

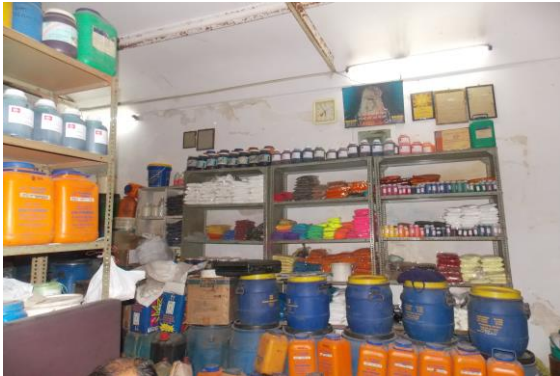
Photo 179

Wall No. 2 of Shop No.6 of Ground Floor Covered With Material

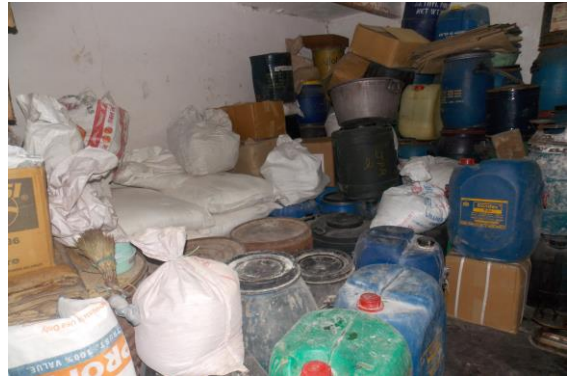
Photo 180

Wall No. 4 of Shop No.6 of Ground Floor Covered With Material

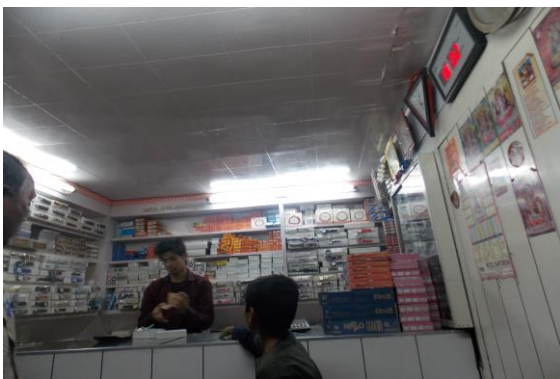
Photo 181

Wall No. 1 of Shop No.6 of Ground Floor Covered With Material

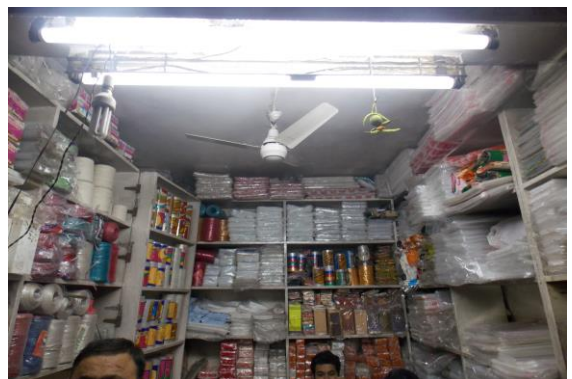
Photo 182

All Walls of Shop No.8 of Ground Floor Covered With Wooden Racks & Material

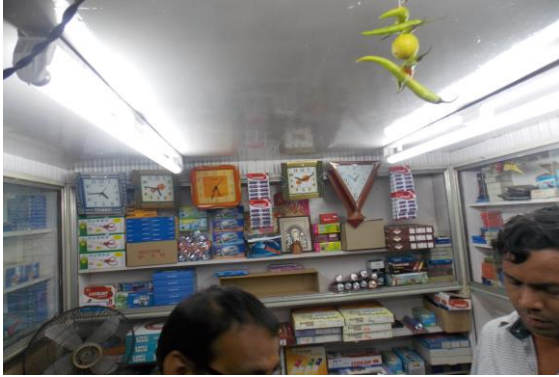
Photo 183

All Walls of Shop No.9 of Ground Floor Covered With Wooden Racks & Material

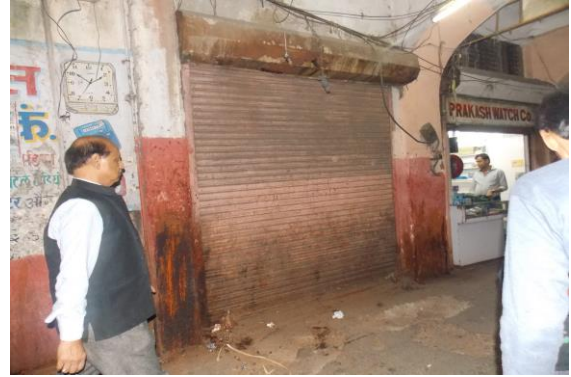
Photo 184

Shop No.10 of Ground Floor Covered With Wooden Racks & Material

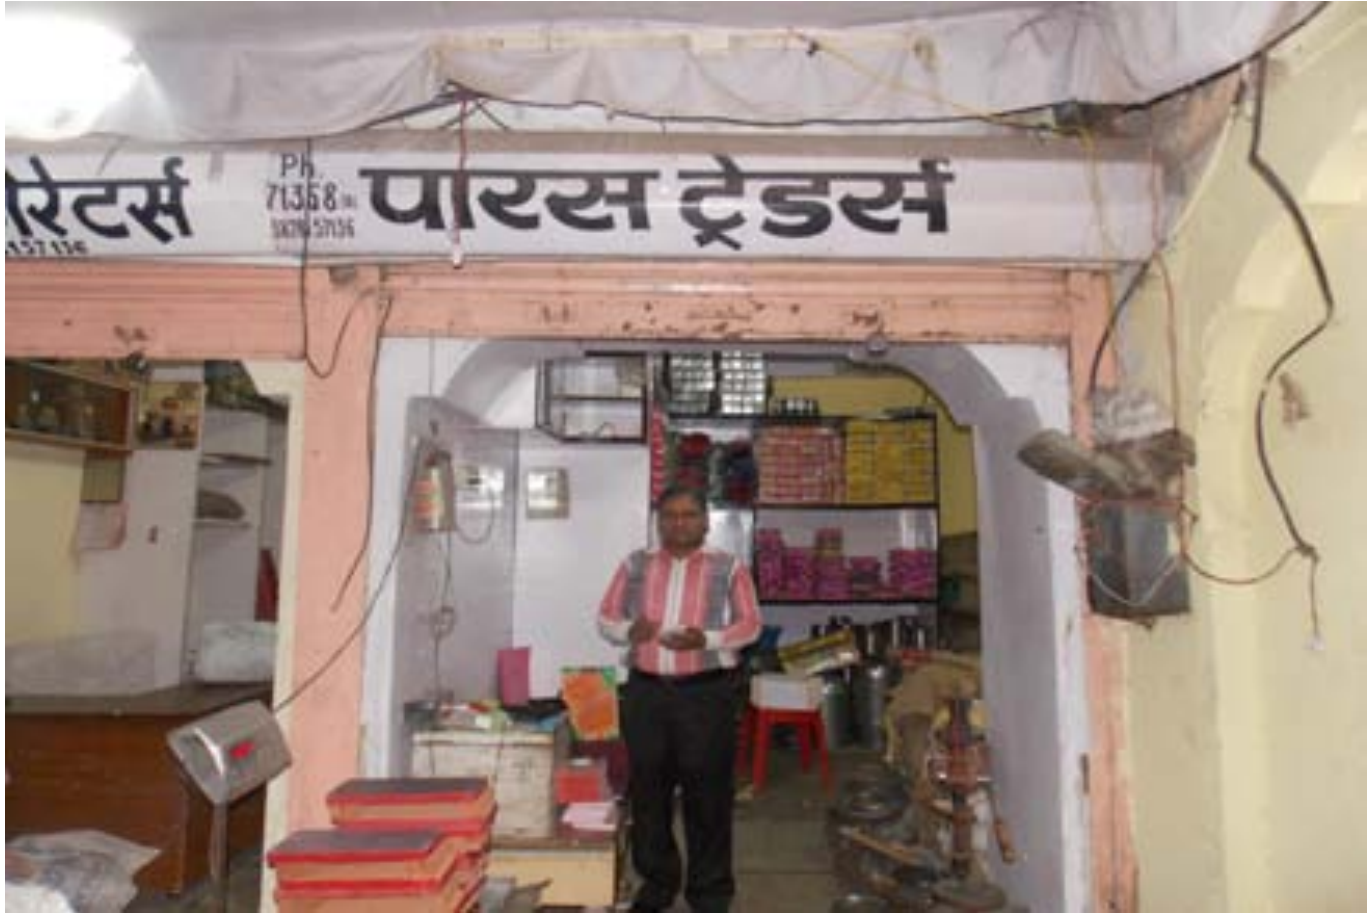
Photo 185

Shop No of Ground Floor Locked

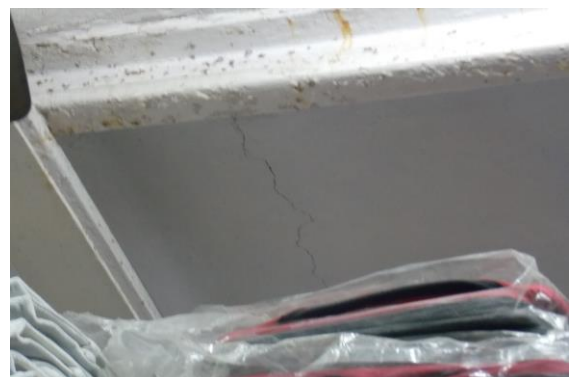
Summary of Cracks						
Defect ID	Location	Orientation	Appx. Width (mm)	Appx. Length (m)	Category	Photo No.
1	Roof Part B Shop Sardari Lal & Sons, Ground Floor	Horizontal	0.6	1	Very Slight	6

Photo 6
Horizontal Crack on Roof of Part B, Shop Sardari Lal & Sons, Ground Floor, Approx. Width = 0.6mm, Approx. Length = 1m. Distance from Wall No.2 = 2.5m, Height from Floor = 2.8m.

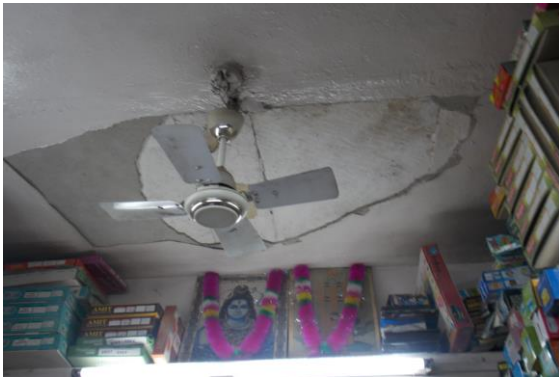
Photo 7

Summary of Defects Other Than Crack			
Defect ID	Location	Description	Photo No.
2	Roof Shop Bharat Watch Co. Ground Floor	Peeling of Plaster	7
3	Wall No. 4 Part A Shop Sardari Lal & Sons, Ground Floor	Dampness/Seepage	8

Peeling of Plaster on Roof of Shop Bharat Watch Co. of Ground Floor

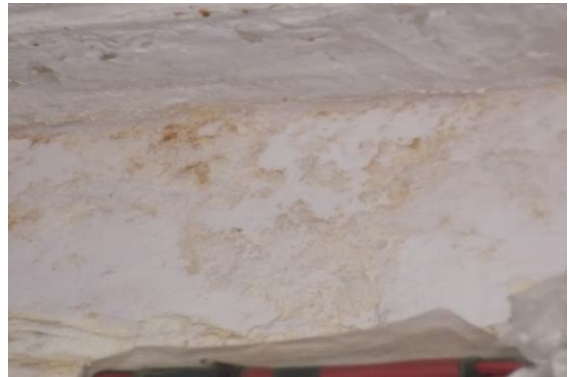
Photo 8

Dampness/Seepage on Wall No. 4 of Part A of Shop Sardari Lal & Sons, Ground Floor

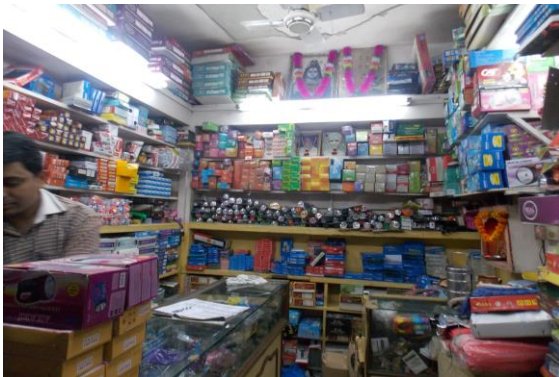
Photo 9

All Walls of Shop Bharat Watch Co. of Ground Floor Covered With Material

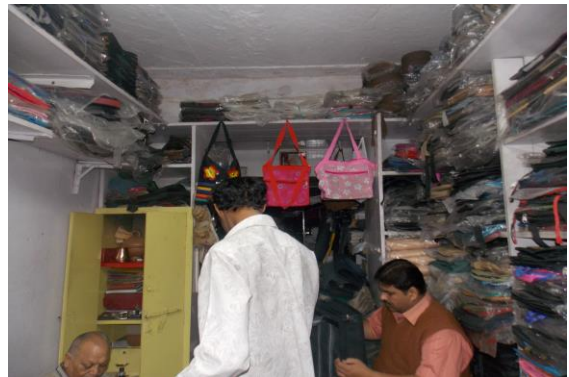
Photo 10

All Walls of Part A of Shop Sardari Lal & Sons, Ground Floor Covered With Wooden Racks & Material

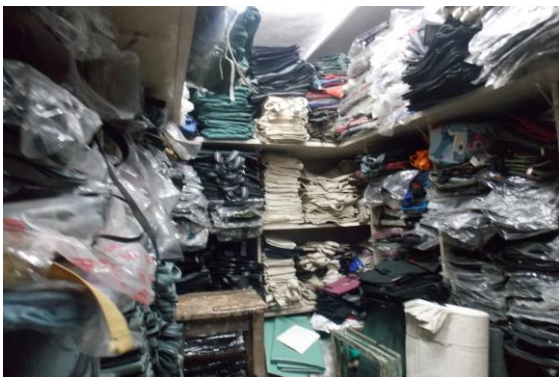
Photo 11

Wall No. 1 & 4 of Part B of Shop Sardari Lal & Sons, Ground Floor Covered With Wooden Racks & Material

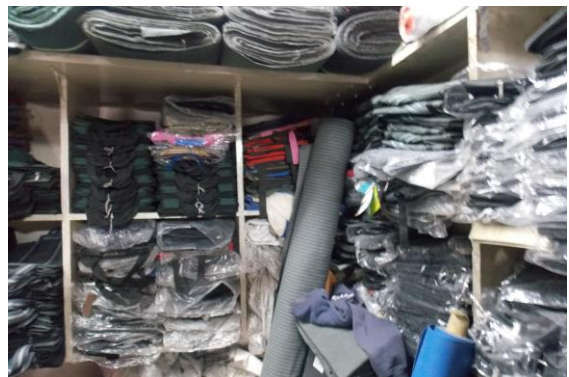
Photo 12

Wall No. 2 & 4 of Part B of Shop Sardari Lal & Sons, Ground Floor Covered With Wooden Racks & Material

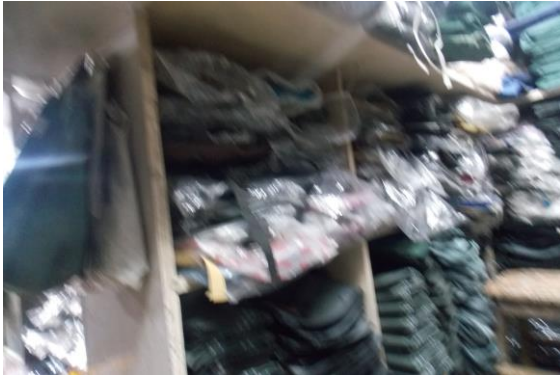
Photo 13

Wall No. 3 of Part B of Shop Sardari Lal & Sons, Ground Floor Covered With Wooden Racks & Material

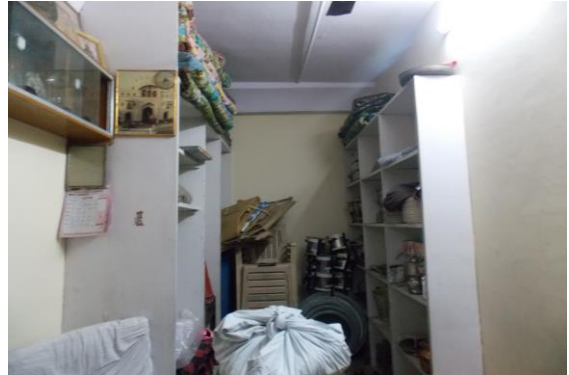
Photo 14

Wall No. 1 & 2 of Shop Shree Kaseera Tent Decorators of Ground Floor Covered With Wooden Racks & Material

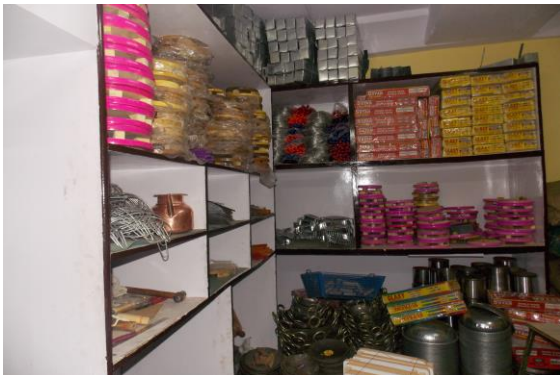
Photo 15

Wall No. 1 & 4 of Shop Paras Traders of Ground Floor Covered With Wooden Racks & Material
