Pre Building Condition Survey Report

Name and Address of Structure :	Choti Chopar to Badi Chopar (Down Line)
---------------------------------	---

Name of the Project	Contract JMRC-UG1B “Design and Construction of Tunnel between Chandpole and Badi Chouper and reverse line by Shield TBM, Underground Metro Stations at Choti Chouper and Badi Chouper by Cut and Cover Methods on East West Corridor of Jaipur Metro Rail Corporation Limited .”	
Owner :

Pre Building Condition Survey Report Choti Chopar to Badi Chopar (Down Line)

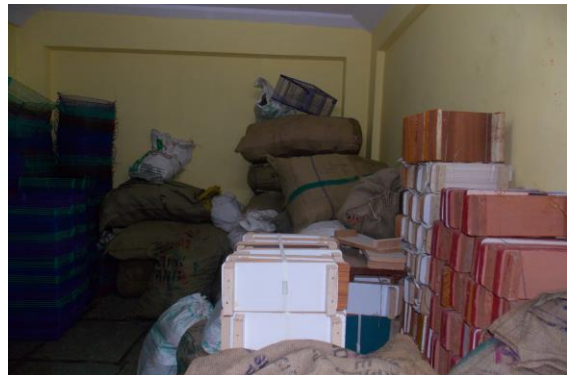
Photo 16

Wall No. 2 & 3 of Shop Paras Traders of Ground Floor Covered With Wooden Racks & Material

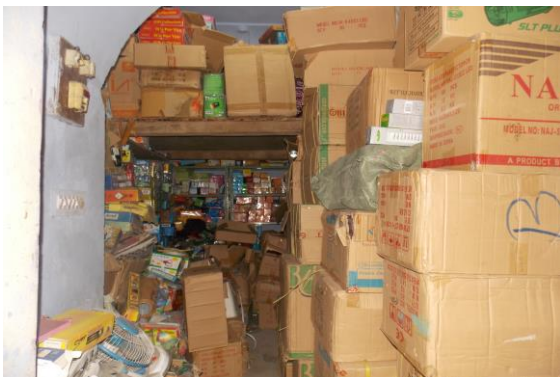
Photo 17

All Walls of Shop Rahul Citi Godown of Ground Floor Covered With Material

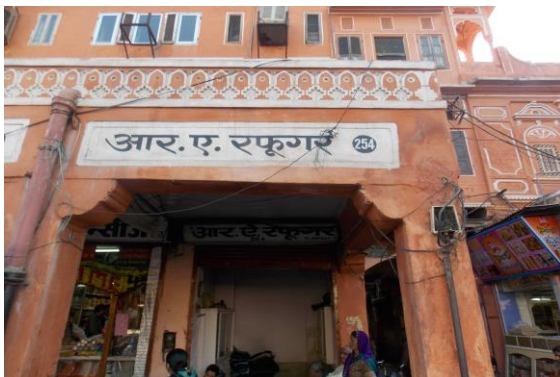
Photo 9
View of Shop No.254, Ground Floor

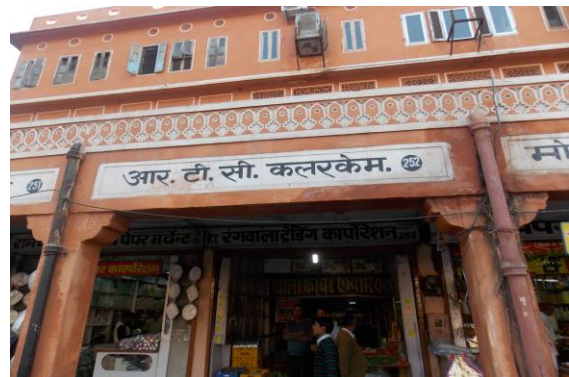
Photo 10
View of Shop No.252, Ground Floor

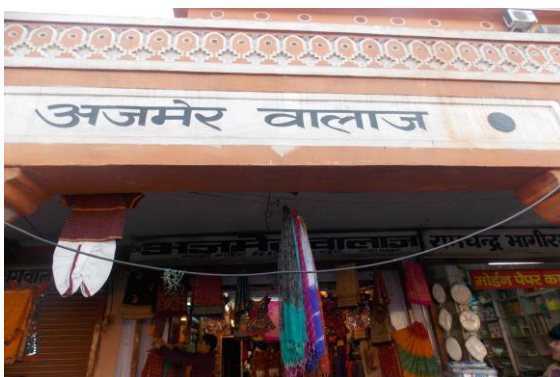
Photo 11
View of Shop No.250, Ground Floor

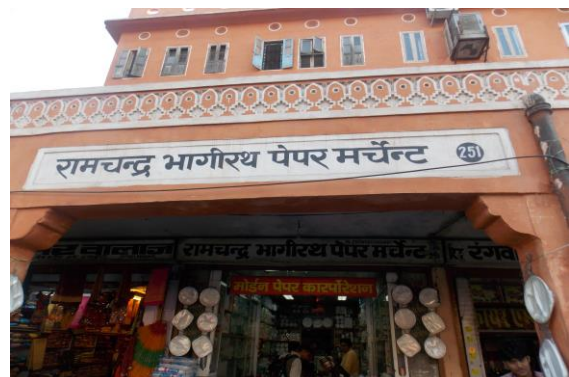
Photo 12
View of Shop No.251, Ground Floor

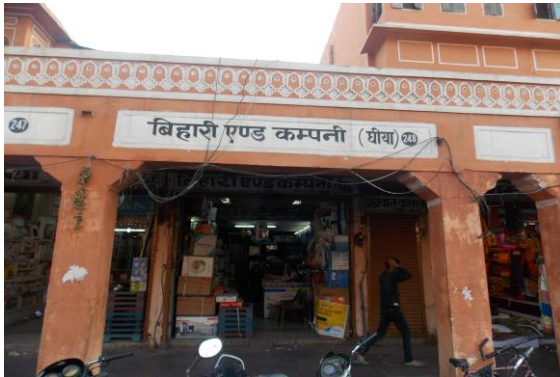
Photo 13
View of Shop No.248, Ground Floor

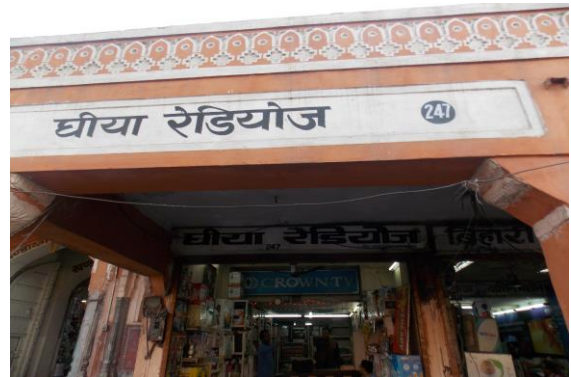
Photo 14
View of Shop No.247 Giya Radios, Ground Floor

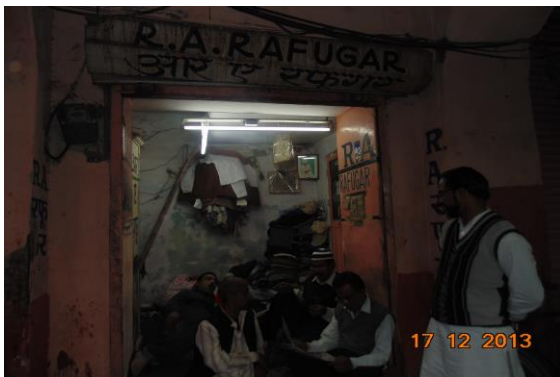
Photo 15
View of Shop Ra Rafugar, Ground Floor

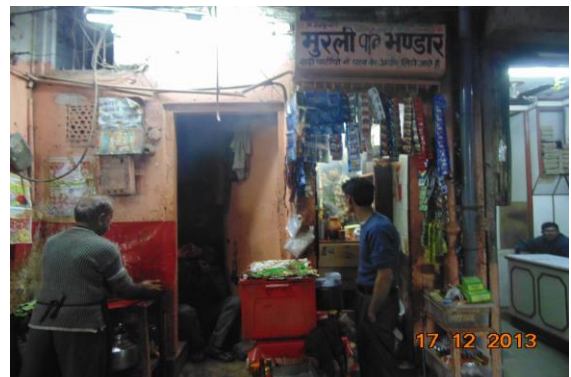
Photo 16
View of Murali Pan Bhandar, Ground Floor

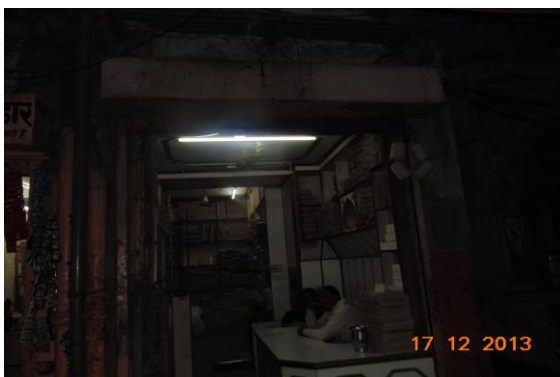
Photo 17
View of Madan Lal & Company, Ground Floor

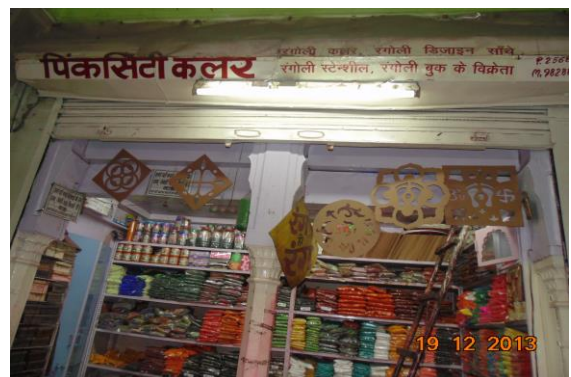
Photo 18
View of Shop Pink city Colour, Ground Floor

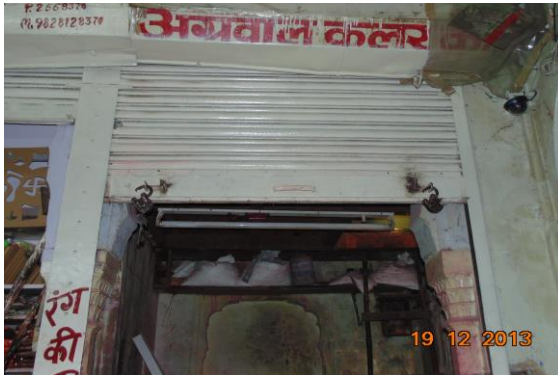
Photo 19
View of Shop Aggarwal Colour, Ground Floor

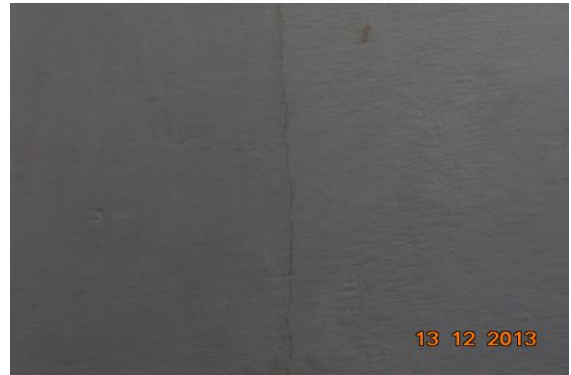
Photo 20
Vertical Crack of Hall No. 2, Ground Floor, Approx. Width = 0.3mm, Approx. Length = 1.5m. Distance from Wall No.3 = 1.5m, Height from Floor = 0m.

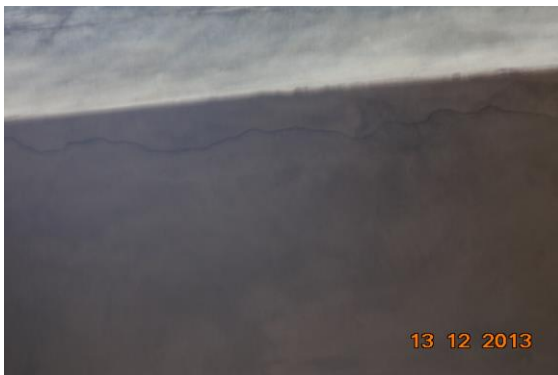
Photo 21
Horizontal Crack on Shade of House No. 635, Third Floor, Approx. Width = 1.5mm, Approx. Length = 3m. Distance from Back Side Wall = 5.3m, Height from Floor = 12m.

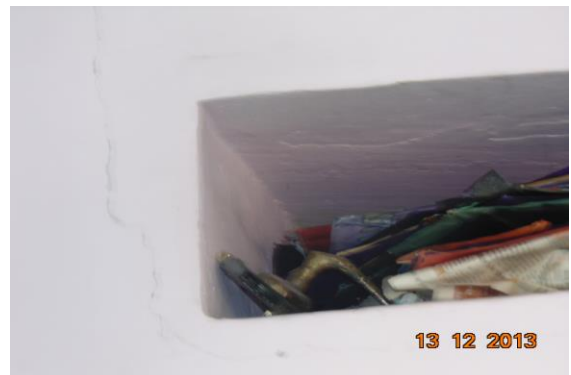
Photo 22
Inclined Crack on Roof of Room No. 3, Second Floor, Approx. Width = 0.15mm, Approx. Length = 1.8m. Distance from Wall No.4 = 2.2m, Height from Floor = 2m.

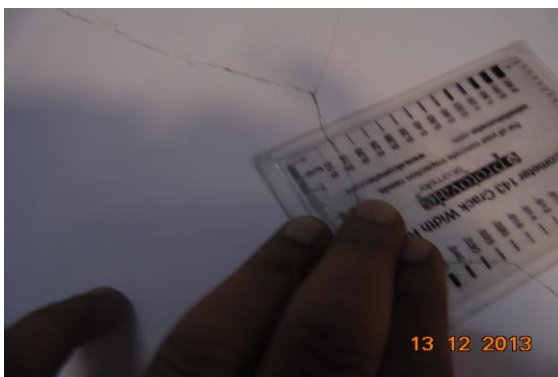
Photo 22A
Inclined Crack on Roof of Room No. 3, Second Floor
Approx. Width = 0.15mm, Approx. Length = 1.8m.
Distance from Wall No.4 = 2.2m, Height from Floor = 2m.

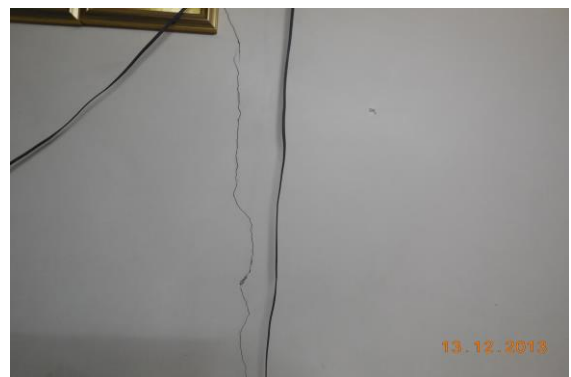
Photo 23
Inclined Crack on Dining Room, House No. 635, First Floor, Approx. Width = 1mm, Approx. Length = 3m. Distance from Wall No.3 = 1.85m, Height from Floor = 0m.

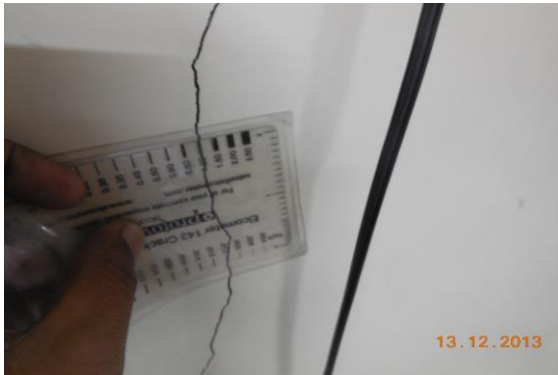
Photo 23A

Inclined Crack of Dining Room, House No. 635, First Floor
Approx. Width = 1mm, Approx. Length = 3m.
Distance from Wall No.3 = 1.85m, Height from Floor = 0m.

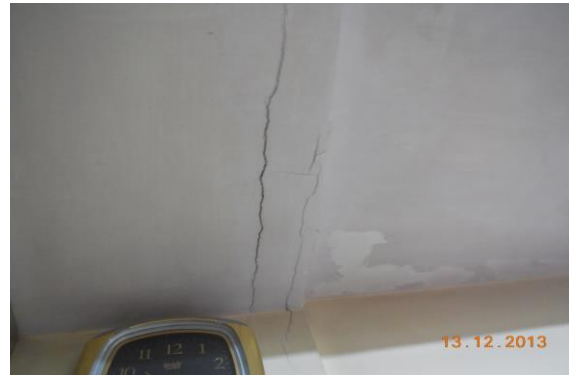
Photo 24

Inclined Crack on Roof of Dining Room, House No. 635, First Floor
Approx. Width = 2mm, Approx. Length = 1m.
Distance from Wall No.3 = 1.85m, Height from Floor = 2.98m.

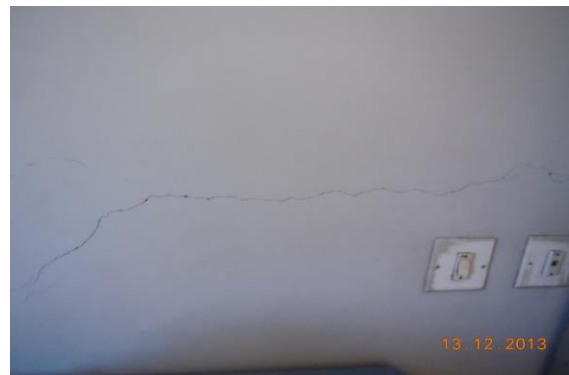
Photo 25A

Inclined Crack on Roof of Room No. 1, First Floor, Approx. Width = 1mm, Approx. Length = 4m. Distance from Wall No.4 = 1.6m, Height from Floor = 0m.

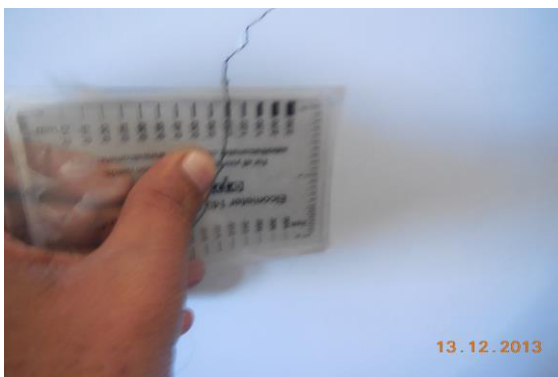
Photo 25A

Inclined Crack on Roof of Room No. 1, First Floor
Approx. Width = 1mm, Approx. Length = 4m.
Distance from Wall No.4 = 1.6m, Height from Floor = 0m.

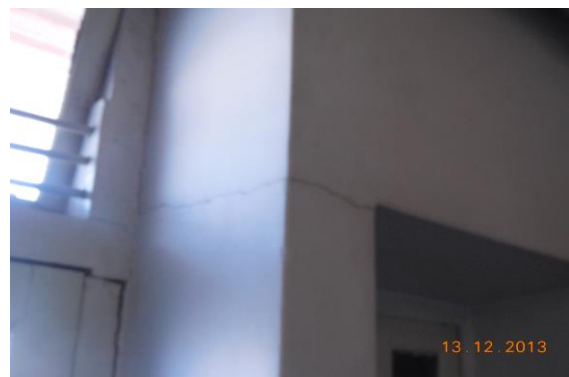
Photo 26

Horizontal Crack on Room No. 1, First Floor
Approx. Width = 1mm, Approx. Length = 1.7m.
Distance from Wall No.2 = 1m, Height from Floor = 2.1m.

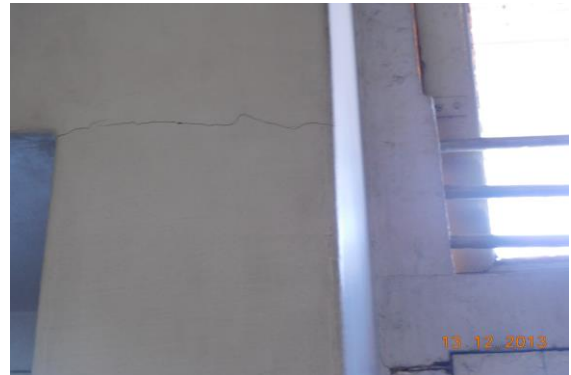
Photo 28

Horizontal Crack on Room No. 1, First Floor
Approx. Width = 0.25mm, Approx. Length = 0.8m.
Distance from Wall No. 1 = 0.9m, Height from Floor = 2.1m.

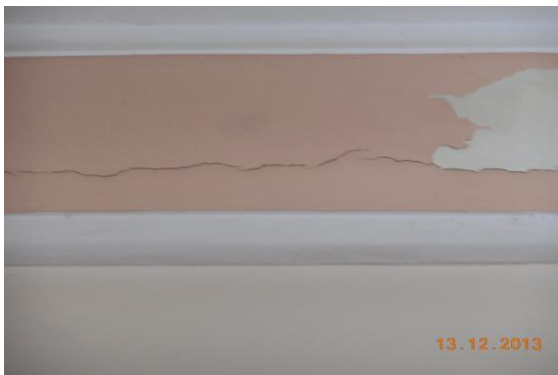
Photo 29

Horizontal Crack on Roof of Room No. 2, First Floor
Approx. Width = 0.8mm, Approx. Length = 2m.
Distance from Wall No.3 = 0m, Height from Floor = 4m.

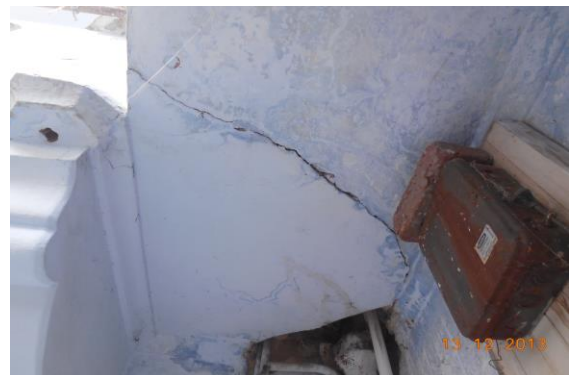
Photo 30

Vertical Crack on Roof of Balcony-3, House No. 635, First Floor
Approx. Width = 0.5mm, Approx. Length = 1m.
Distance from Balcony-2 = 0.2m, Height from Floor = 3m.

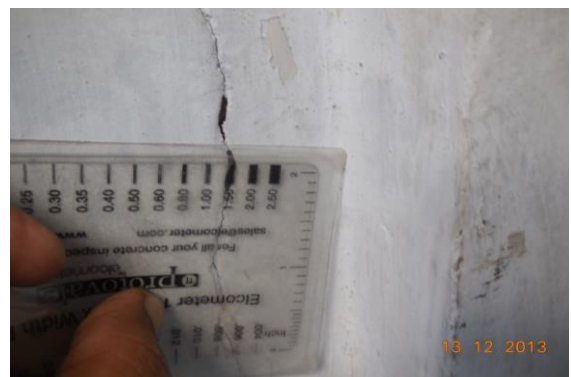
Photo 31A

Inclined Crack on Roof of Sky Open Lobby, House No. 635, First Floor, Approx. Width = 1.5mm, Approx. Length = 3m. Distance from Wall No. 1 = 0.6m, Height from Floor = 0m.

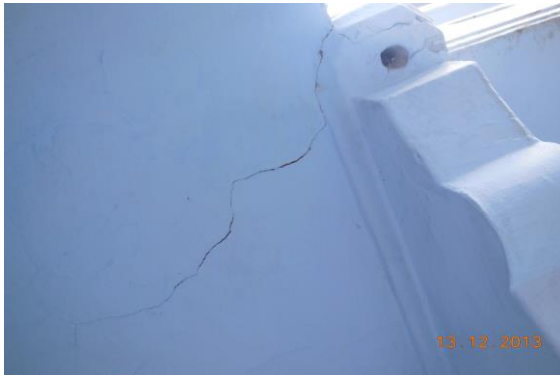
Photo 32

Inclined Crack on Roof of Balcony-1, House No. 635, First Floor, Approx. Width = 0.6mm, Approx. Length = 1m. Distance from Wall No.3 = 0.15m, Height from Floor = 3m.

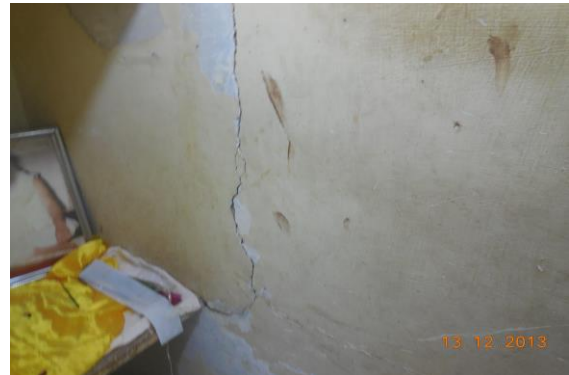
Photo 33

Vertical Crack on Roof of Hall No. 1, Second Floor, Approx. Width = 2.5mm, Approx. Length = 1m. Distance from Wall No. 5 = 0.6m, Height from Floor = 0.5m.

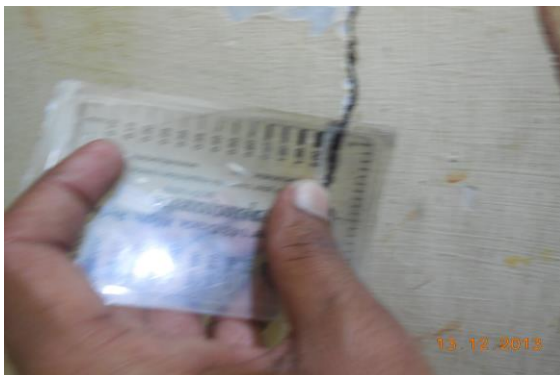
Photo 33A

Vertical Crack on Roof of Hall No. 1, Second Floor Approx. Width = 2.5mm, Approx. Length = 1m. Distance from Wall No. 5 = 0.6m, Height from Floor = 0.5m.

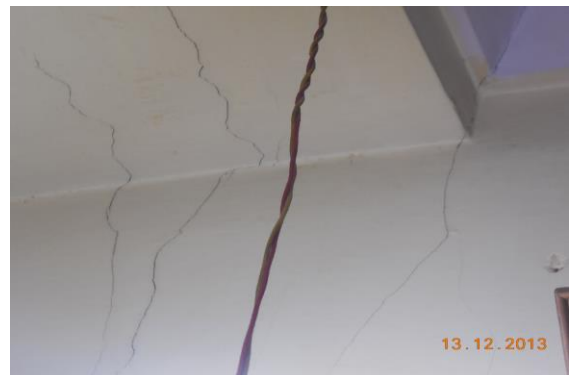
Photo 34

Inclined Crack on Wall No.4 & Roof of Hall No. 1, Second Floor, Approx. Width = 0.8mm, Approx. Length = 5m. Distance from Wall No. 5 = 0.7m, Height from Floor = 1.1m.

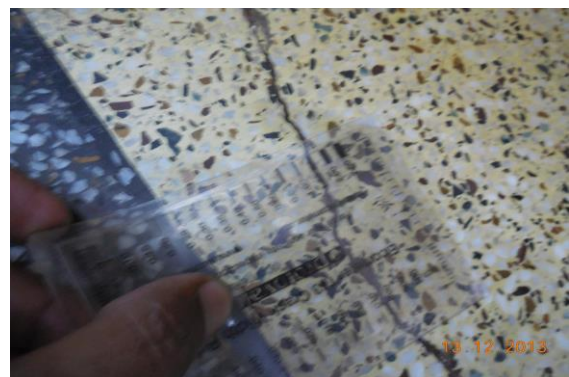
Photo 35A

Horizontal Crack on Floor of Hall No. 1, Second Floor, Approx. Width = 1.5mm, Approx. Length = 0.6m. Distance from Wall No.4 = 0m, Height from Floor = 0m.

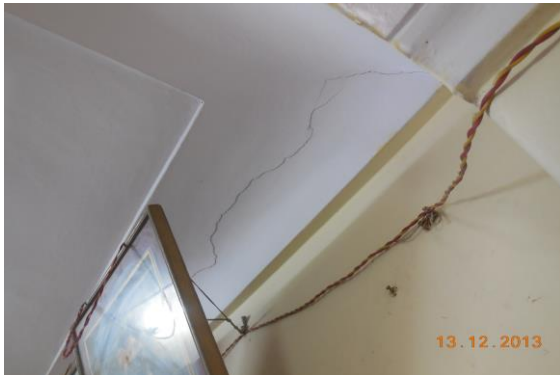
Photo 36

Inclined Crack on Roof of Hall No. 1, Second Floor, Approx. Width = 0.6mm, Approx. Length = 2.1m. Distance from Wall No.3 = 0m, Height from Floor = 2.9m.

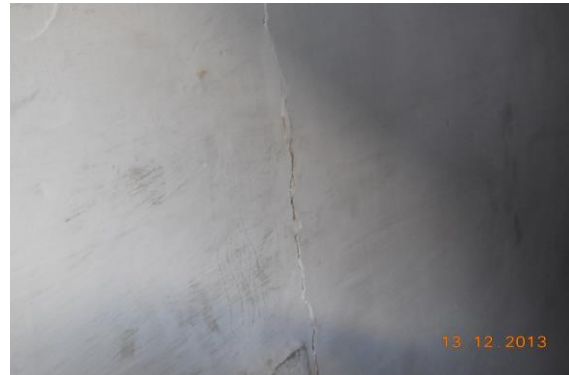
Photo 37

Horizontal Crack on Roof of Gallery-1, House No. 635, First Floor, Approx. Width = 1mm, Approx. Length = 2m. Distance from Wall No.3 = 0.9m, Height from Floor = 0m.

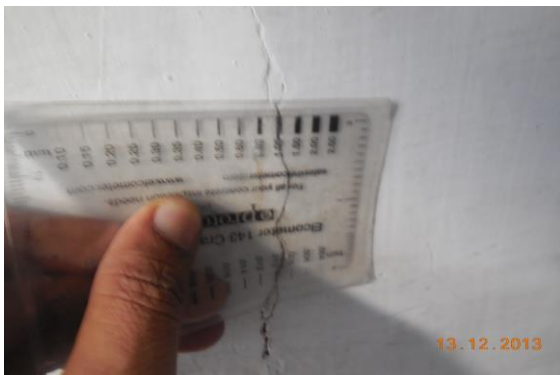
Photo 37A

Horizontal Crack on Roof of Gallery-1, House No. 635, First Floor, Approx. Width = 1mm, Approx. Length = 2m. Distance from Wall No.3 = 0.9m, Height from Floor = 0m.

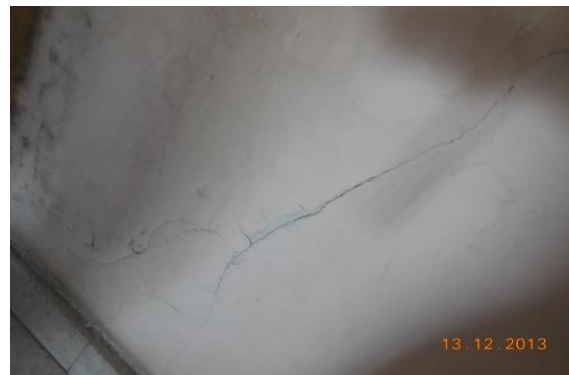
Photo 38

Inclined Crack on Roof of Kitchen, House No. 635, Second Floor, Approx. Width = 0.6mm, Approx. Length = 1m. Distance from Wall No.3 = 0m, Height from Floor = 0m.

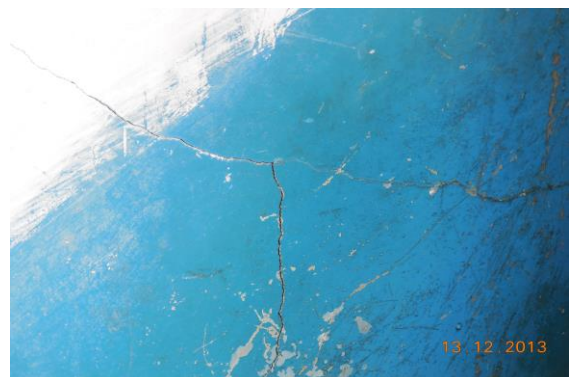
Photo 39

Inclined Crack on Stair Case, House No. 635, Second Floor, Approx. Width = 0.6mm, Approx. Length = 2m. Distance from Wall No.4 = 0.7m, Height from Floor = 0m.

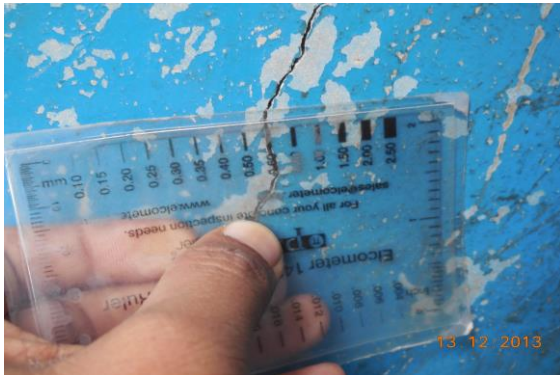
Photo 39A

Inclined Crack on of Stair Case, House No. 635, Second Floor, Approx. Width = 0.6mm, Approx. Length = 2m. Distance from Wall No.4 = 0.7m, Height from Floor = 0m.

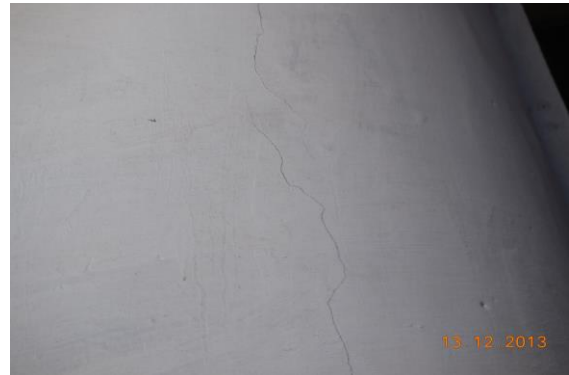
Photo 40

Inclined Crack on of Stair Case, House No. 635, Second Floor, Approx. Width = 0.25mm, Approx. Length = 1m. Distance from Wall No.4 = 0.7m, Height from Floor = 1m.

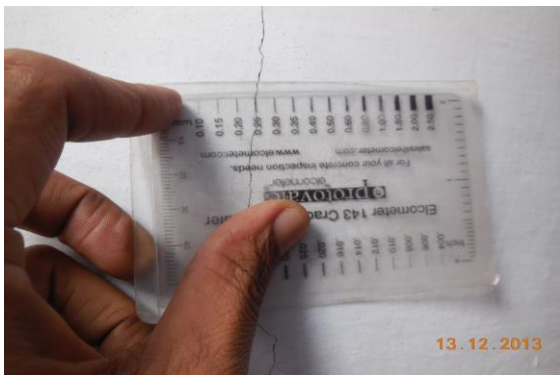
Photo 40A

Inclined Crack on of Stair Case, House No. 635, Second Floor, Approx. Width = 0.25mm, Approx. Length = 1m. Distance from Wall No.4 = 0.7m, Height from Floor = 1m.

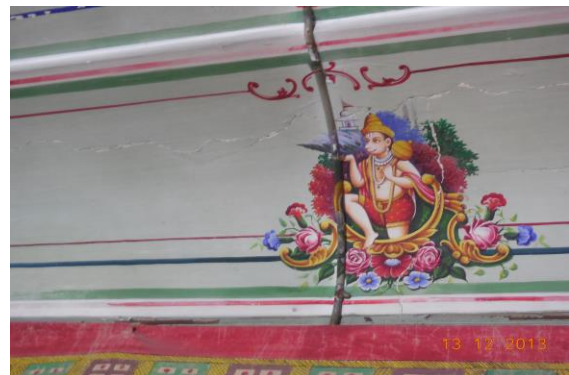
Photo 41

Horizontal Crack on Roof of Room No. 3, Second Floor, Approx. Width = 0.35mm, Approx. Length = 2.5m. Distance from Wall No. 1 = 0m, Height from Floor = 2.5m.

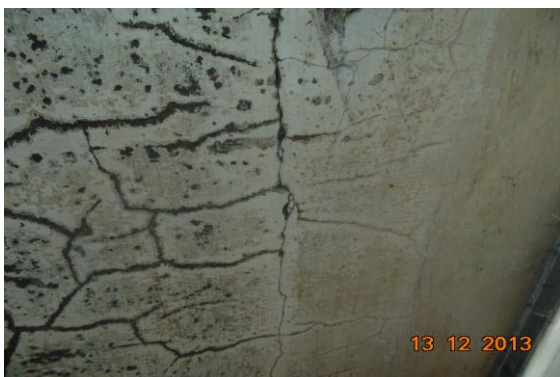
Photo 42

Vertical Crack on Roof of Sky Open Lobby, House No. 635, Second Floor, Approx. Width = 5mm, Approx. Length = 2m. Distance from Wall No.4 = 0.6m, Height from Floor = 0m.

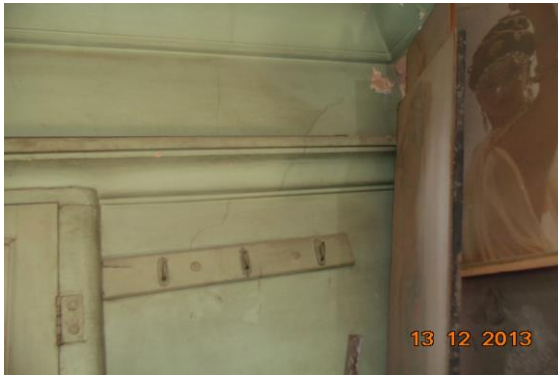
Photo 44

Inclined Crack on Roof of Room No. 11, Second Floor, Approx. Width = 0.6mm, Approx. Length = 0.6m. Distance from Wall No.3 = 0.15m, Height from Floor = 1m.

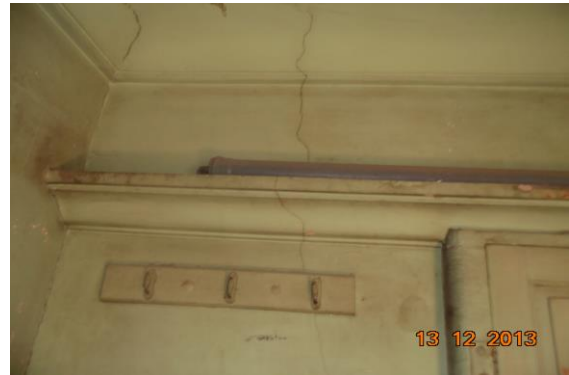
Photo 45

Inclined Crack on Roof of Room No. 11, Second Floor Approx. Width = 0.6mm, Approx. Length = 0.6m. Distance from Wall No.4 = 1.7m, Height from Floor = 1m.

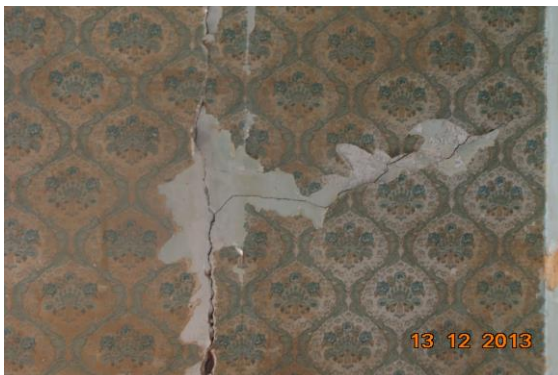
Photo 46

Inclined Crack on Roof of Room No. 12, Second Floor Approx. Width = 1.6mm, Approx. Length = 2.75m. Distance from Wall No.4 = 0.6m, Height from Floor = 0m.

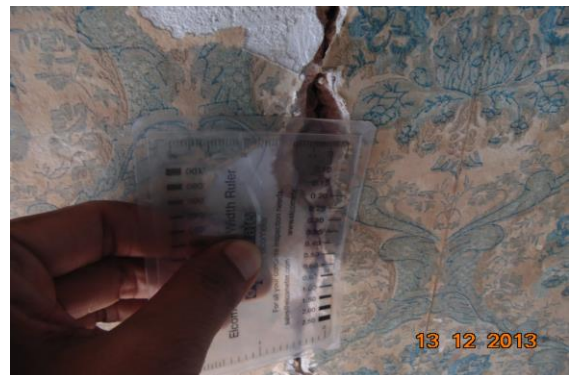
Photo 46A

Inclined Crack on Roof of Room No. 12, Second Floor Approx. Width = 1.6mm, Approx. Length = 2.75m. Distance from Wall No.4 = 0.6m, Height from Floor = 0m.

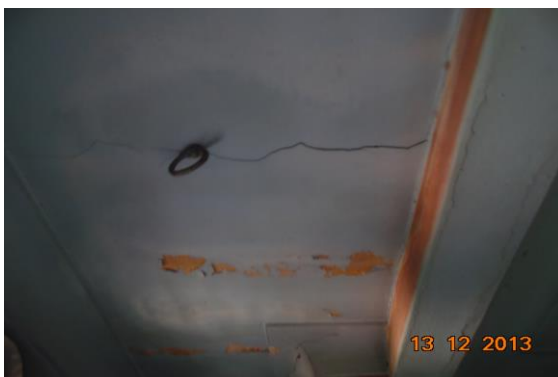
Photo 47

Inclined Crack on Roof of Room No. 13, Second Floor Approx. Width = 3mm, Approx. Length = 1.1m. Distance from Wall No.2 = 1.5m, Height from Floor = 2.5m.

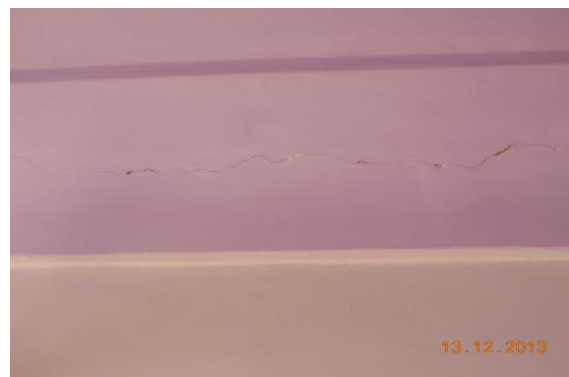
Photo 48

Inclined Crack on Roof of Room No. 6, Second Floor Approx. Width = 0.35mm, Approx. Length = 2m. Distance from Wall No.3 = 0.25m, Height from Floor = 2.9m.

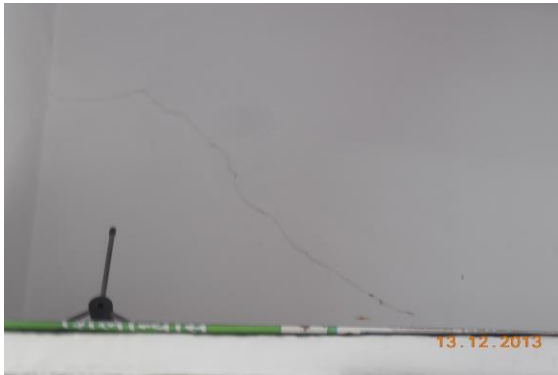
Photo 49

Inclined Crack on Roof of Room No. 6, Second Floor
Approx. Width = 0.25mm, Approx. Length = 0.8m.
Distance from Wall No.4 = 0.3m, Height from Floor = 2m.

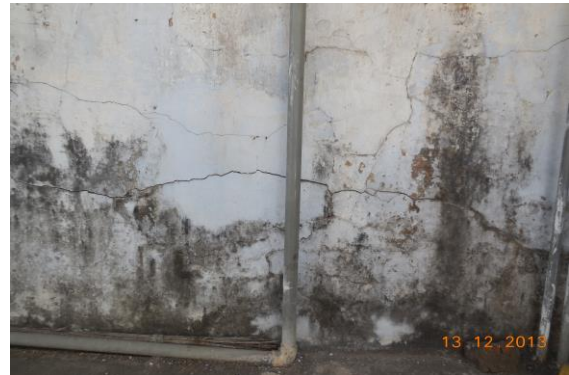
Photo 50

Inclined Crack on Outer Wall of Sky Open Lobby, House No. 635, Second Floor, Approx. Width = 2mm, Approx. Length = 2m.
Distance from Wall No. 1 = 0.3m, Height from Floor = 1.5m.

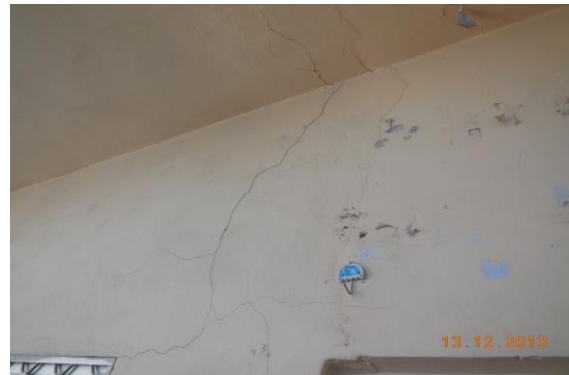
Photo 52

Inclined Crack on Wall No.3 & Roof of Balcony Shade, House No. 635, Third Floor, Approx. Width = 0.8mm, Approx. Length = 2.2m.
Distance from Wall No.2 = 1m, Height from Floor = 2m.

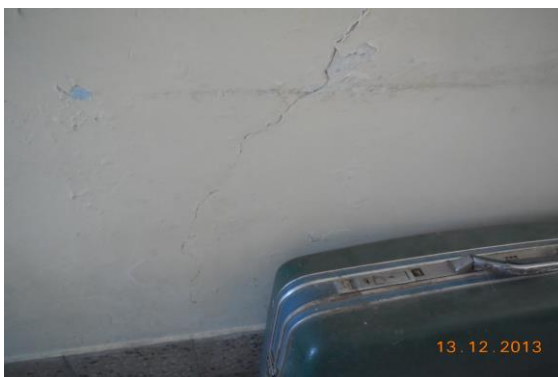
Photo 53

Inclined Crack on Roof of Room No. 2, Third Floor
Approx. Width = 1mm, Approx. Length = 0.8m.
Distance from Wall No. 1 = 0.5m, Height from Floor = 0.2m.

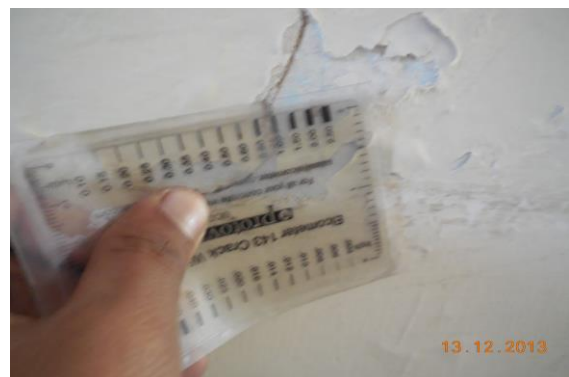
Photo 53A

Inclined Crack on Roof of Room No. 2, Third Floor
Approx. Width = 1mm, Approx. Length = 0.8m.
Distance from Wall No. 1 = 0.5m, Height from Floor = 0.2m.

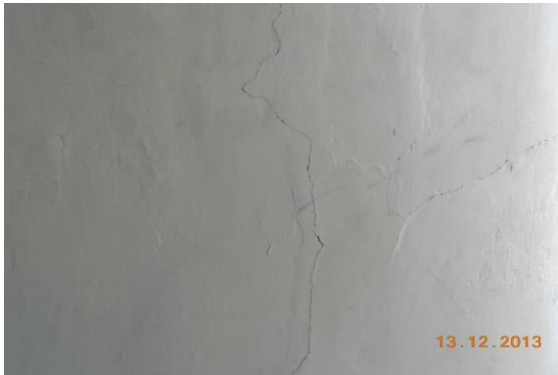
Photo 54

Inclined Crack on Roof of Room No. 2, Third Floor
Approx. Width = 2mm, Approx. Length = 2m.
Distance from Wall No. 1 = 1.1m, Height from Floor = 0m.

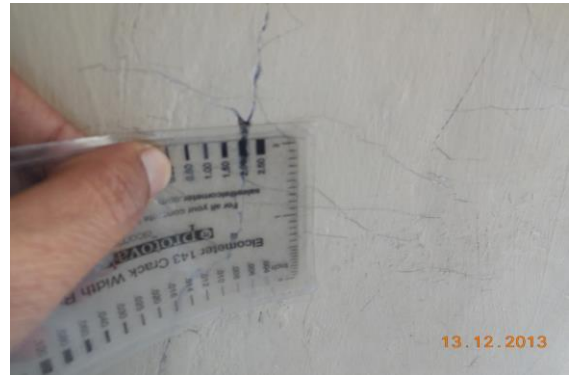
Photo 54A

Inclined Crack on Roof of Room No. 2, Third Floor
Approx. Width = 2mm, Approx. Length = 2m.
Distance from Wall No. 1 = 1.1m, Height from Floor = 0m.

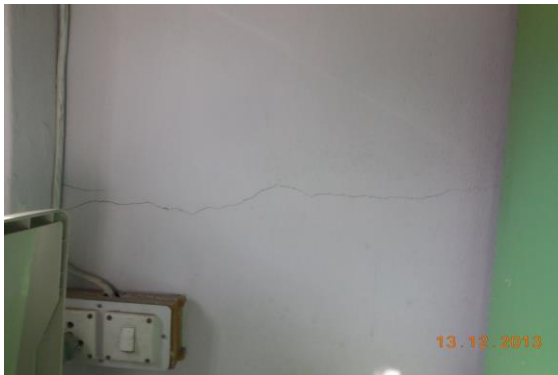
Photo 55

Inclined Crack on Floor & All Wall of Lobby, House No. 635, Third Floor, Approx. Width = 0.3mm, Approx. Length = 0.6m.
Distance from Wall No.4 = 0m, Height from Floor = 1.5m.

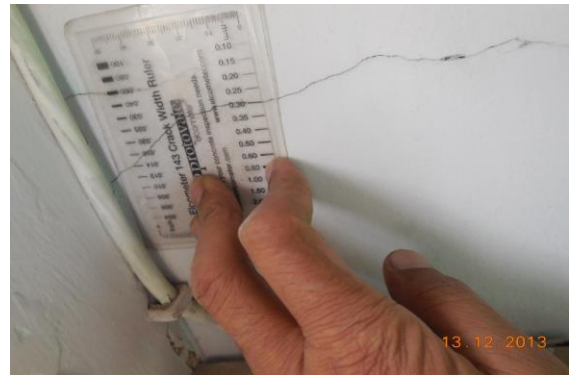
Photo 55A

Inclined Crack on Floor & All Wall of Lobby, House No. 635, Third Floor, Approx. Width = 0.3mm, Approx. Length = 0.6m.
Distance from Wall No.4 = 0m, Height from Floor = 1.5m.

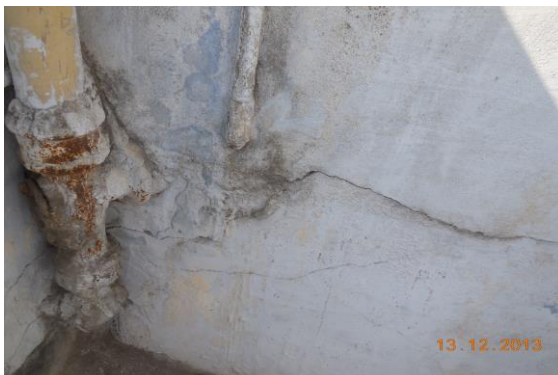
Photo 56

Inclined Crack on Outer Wall of House No. 635, Third Floor, Approx. Width = 0.5mm, Approx. Length = 1.5m.
Distance from Wall No. 1 = 0m, Height from Floor = 0.4m.

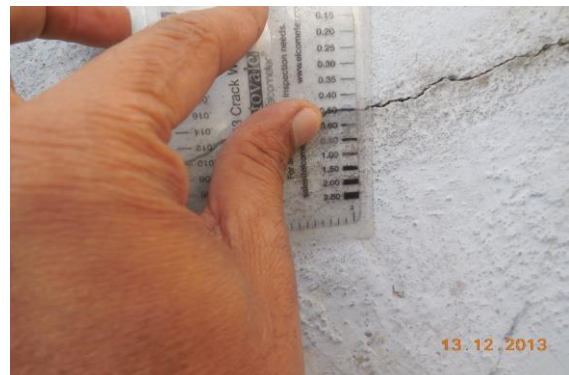
Photo 56A

Inclined Crack on Outer Wall of House No. 635, Third Floor, Approx. Width = 0.5mm, Approx. Length = 1.5m.
Distance from Wall No. 1 = 0m, Height from Floor = 0.4m.

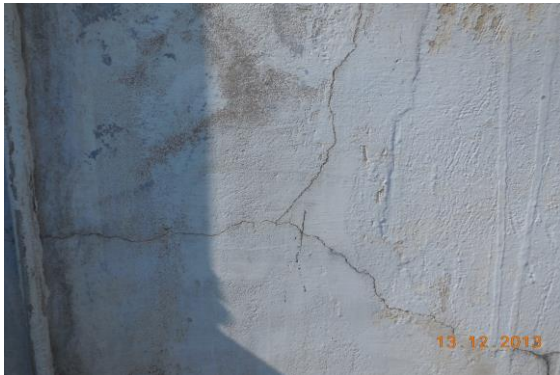
Photo 57

Inclined Crack on Outer Wall of House No. 635, Third Floor,,Approx.
Width = 0.3mm, Approx. Length = 2m.
Distance from Wall No. 1' = 0.4m, Height from Floor = 0.8m.

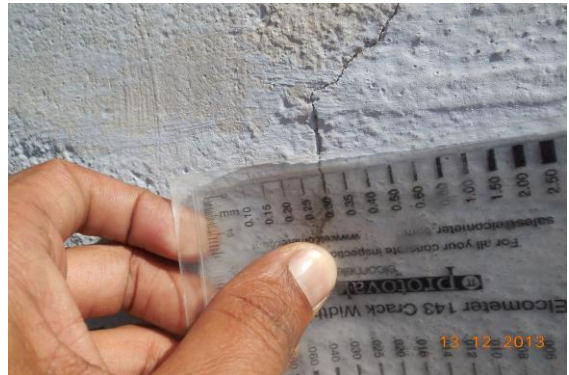
Photo 57A

Inclined Crack on Outer Wall of House No. 635, Third Floor,Approx.
Width = 0.3mm, Approx. Length = 2m.
Distance from Wall No. 1' = 0.4m, Height from Floor = 0.8m.

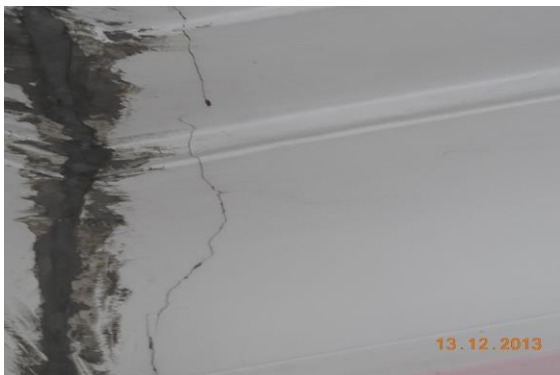
Photo 58

Inclined Crack on Roof of Room No. 5, Second Floor
Approx. Width = 0.5mm, Approx. Length = 1.5m.
Distance from Wall No.3 = 1.2m, Height from Floor = 2.9m.

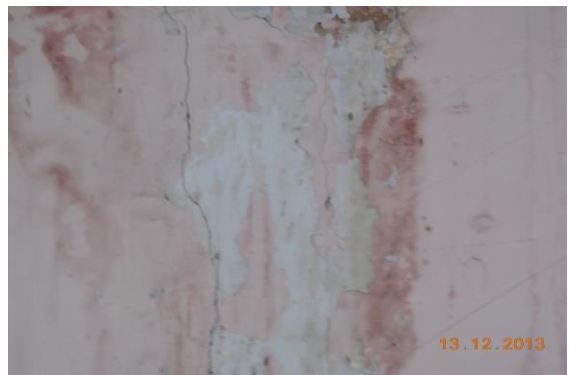
Photo 59

Inclined Crack on Roof of Room No. 5, Second Floor
Approx. Width = 0.4mm, Approx. Length = 2m.
Distance from Wall No.3 = 3m, Height from Floor = 0.6m.

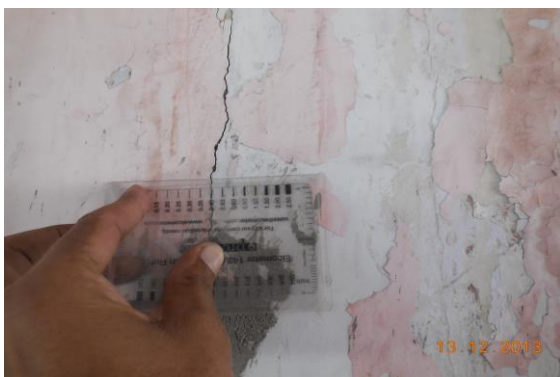
Photo 59A

Inclined Crack on Roof of Room No. 5, Second Floor
Approx. Width = 0.4mm, Approx. Length = 2m.
Distance from Wall No.3 = 3m, Height from Floor = 0.6m.

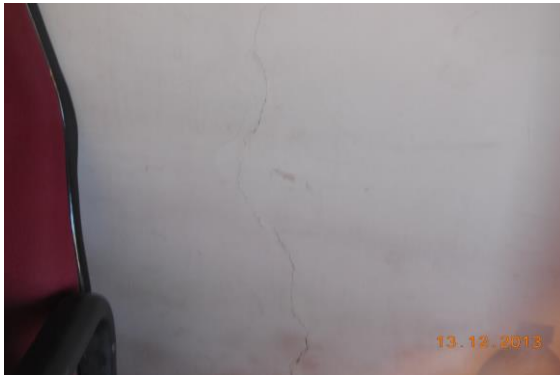
Photo 60

Inclined Crack on Wall No.1 & Roof of Room No. 5, Second Floor
Approx. Width = 0.5mm, Approx. Length = 2.9m.
Distance from Wall No.4 = 2.4m, Height from Floor = 0.25m.

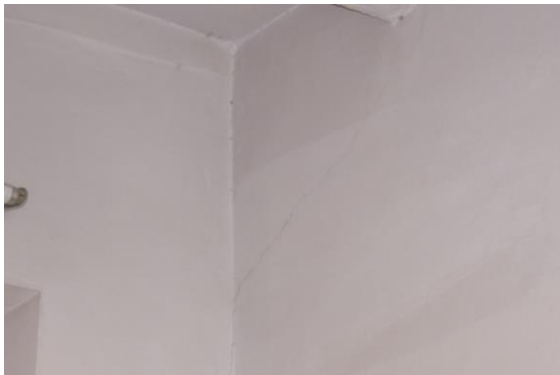
Photo 61

Inclined Crack on Wall No. 2 & 4 of Shop No.254, Ground Floor
Approx. Width = 0.25mm, Approx. Length = 1.5m.
Distance from Wall No.2 & 4 = 0m, Height from Floor = 1.5m.

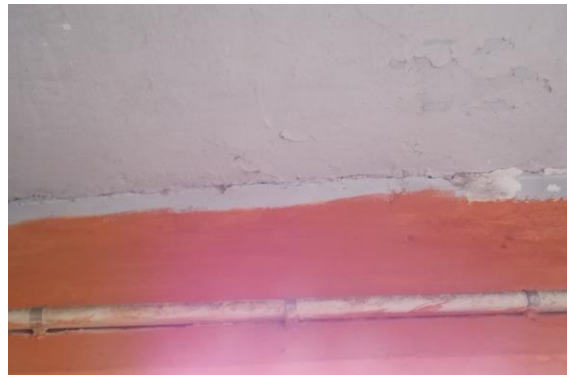
Photo 62

Horizontal Crack on Roof of Varanda of Shop No.254, Ground Floor, Approx. Width = 0.25mm, Approx. Length = 1.5m. Distance from Right-side External Column = 0m, Height from Floor = 3.5m.

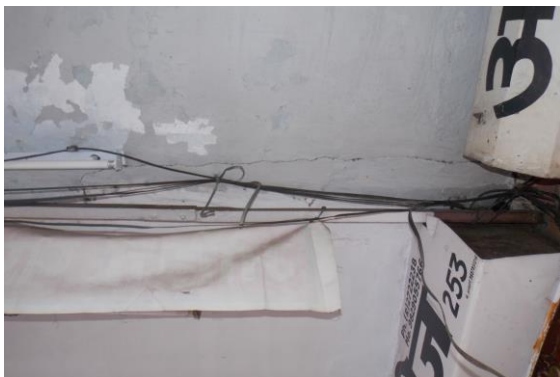
Photo 63

Horizontal Crack on Roof of Varanda of Shop No.254, Ground Floor, Approx. Width = 2.5mm, Approx. Length = 1.5m. Distance from Left side External Column = 0m, Height from Floor = 3.5m.

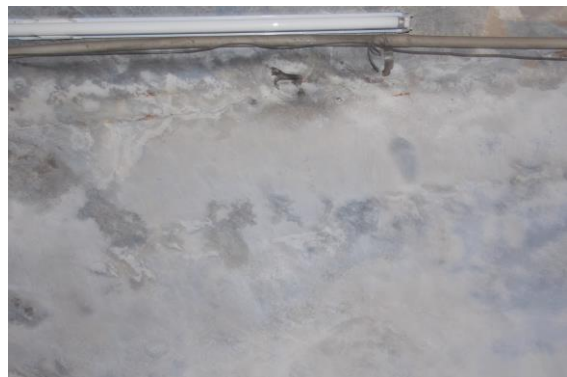
Photo 64

Horizontal Crack on Roof of Varanda of Shop No.252, Ground Floor, Approx. Width = 0.5mm, Approx. Length = 2m.

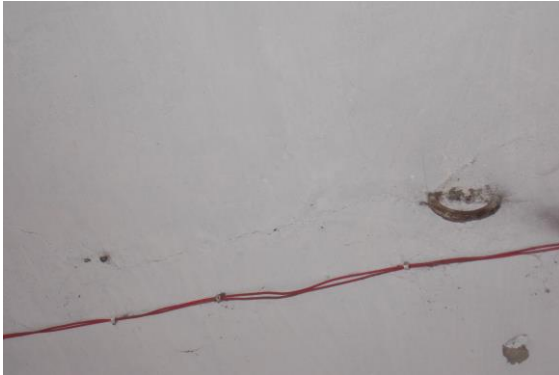
Photo 65

Horizontal Crack on Roof of Varanda of Shop No.250, Ground Floor, Approx. Width = 0.2mm, Approx. Length = 2.5m. Distance from Left side External Column = 1.5m, Height from Floor = 3m.

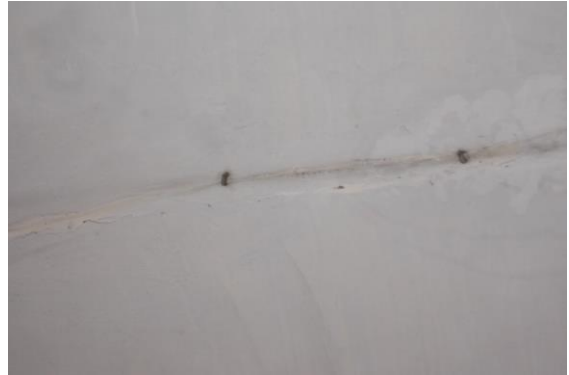
Photo 66

Inclined Crack on Roof of Varanda of Shop No.250, Ground Floor, Approx. Width = 0.35mm, Approx. Length = 2.5m. Distance from Right-side External Column = 0m, Height from Floor = 3m.

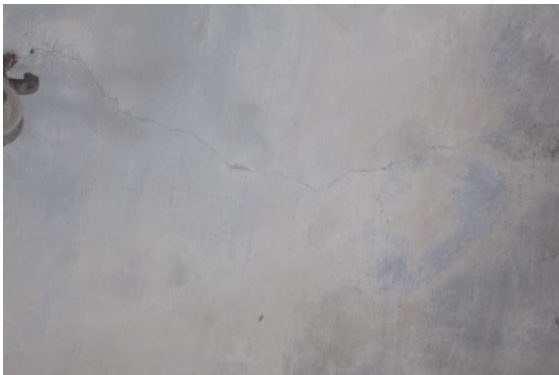
Photo 67

Horizontal Crack on Roof of Varanda of Shop No.251, Ground Floor, Approx. Width = 1.5mm, Approx. Length = 2m. Distance from Left side External Column = 1.6m, Height from Floor = 3m.

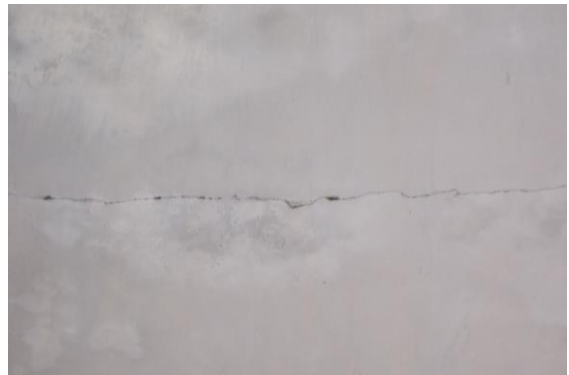
Photo 68

Horizontal Crack on Roof of Varanda of Shop No.248, Ground Floor, Approx. Width = 0.35mm, Approx. Length = 2.5m. Distance from Right-side External Column = 0.2m, Height from Floor = 3m.

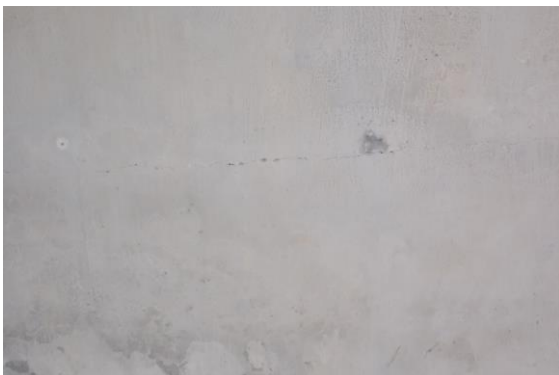
Photo 69

Horizontal Crack on Roof of Varanda of Shop No.248, Ground Floor, Approx. Width = 0.1mm, Approx. Length = 2.5m. Distance from Right-side External Column = 0.5m, Height from Floor = 3m.

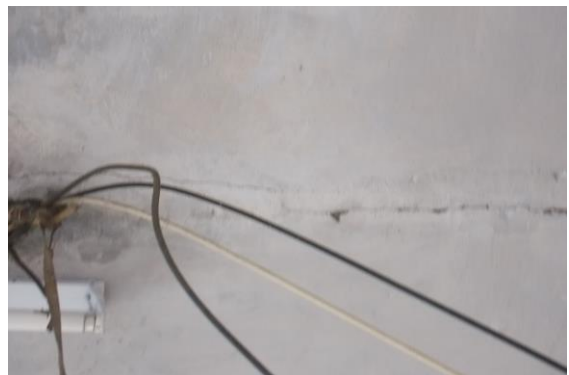
Photo 70

Horizontal Crack on Roof of Varanda of Shop No.248, Ground Floor, Approx. Width = 0.25mm, Approx. Length = 2.5m. Distance from Left side External Column = 0m, Height from Floor = 3m.

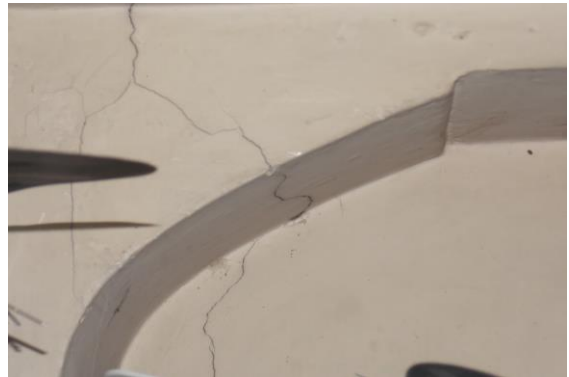
Photo 72

Inclined Crack on Wall No. 4 of Shop No.247, Ground Floor
Approx. Width = 1mm, Approx. Length = 2.5m.
Distance from Wall No.1 = 1m, Height from Floor = 0m.

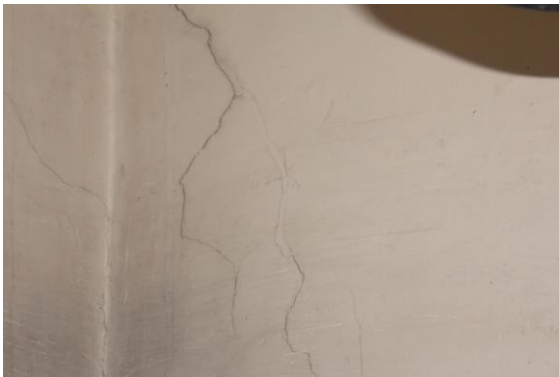
Photo 73

Inclined Crack on Wall No. 4 of Shop No.247, Ground Floor
Approx. Width = 1.6mm, Approx. Length = 2m.
Distance from Wall No.1 = 1.4m, Height from Floor = 1m.

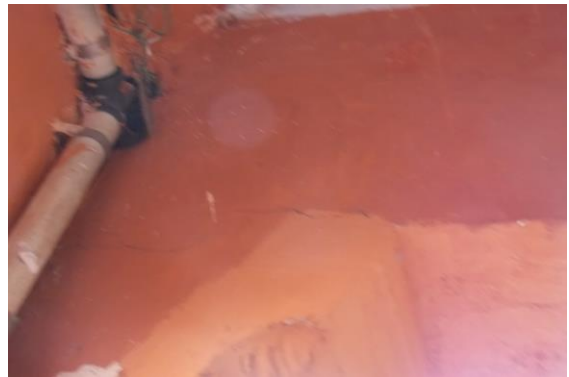
Photo 74

Inclined Crack on Wall No. Left side External Beam of Varanda of Shop No.247, Ground Floor
Approx. Width = 0.35mm, Approx. Length = 0.8m.
Distance from Left side External Column = 0m Height from Floor =

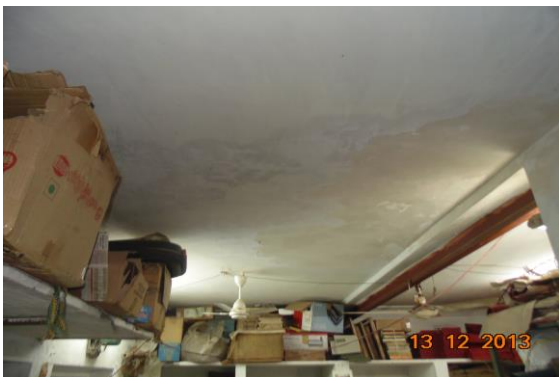
Photo 75

Dampness/Seepage on Roof of Hall No. 1 of Ground Floor

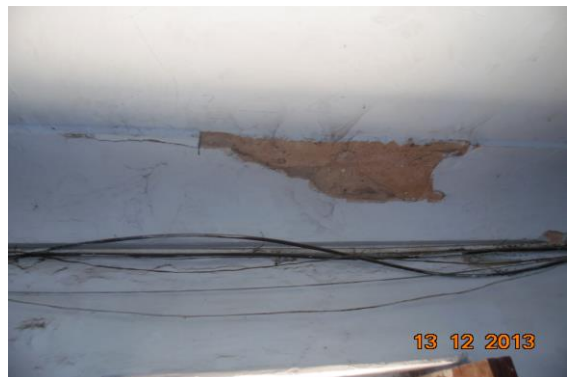
Photo 76

Damaged Portion on Roof of Lobby of House No. 635, Ground Floor

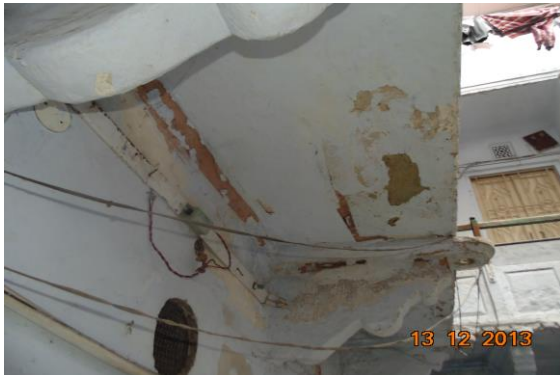
Photo 77

Peeling of Plaster on Shade of Open Sky of House No. 635, Ground Floor

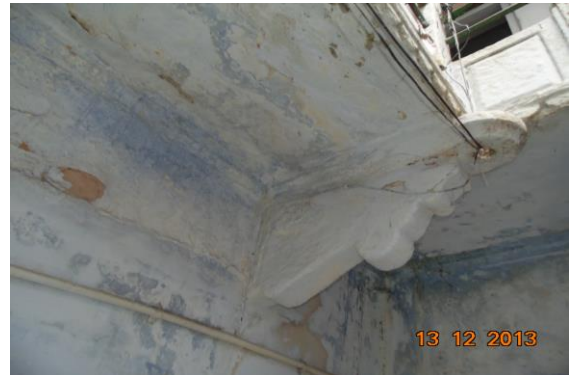
Photo 78

Dampness/Seepage on Shade of Open Sky of House No. 635, Ground Floor

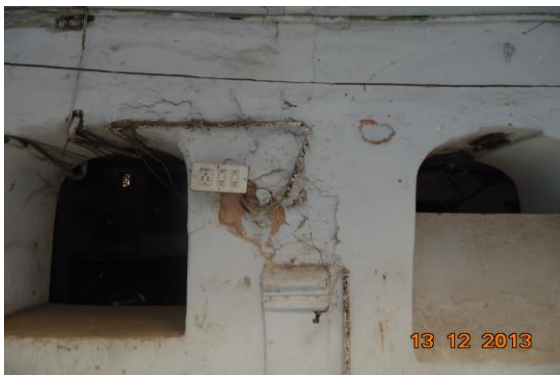
Photo 79

Dampness/Seepage on Shade of Open Sky of House No. 635, Ground Floor

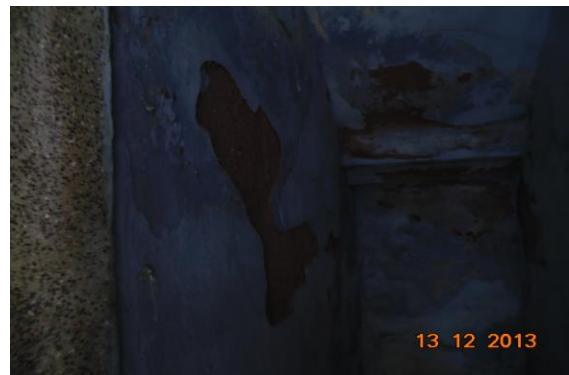
Photo 80

Dampness/Seepage on Shade of Store Under Stair Case of House No. 635, Ground Floor

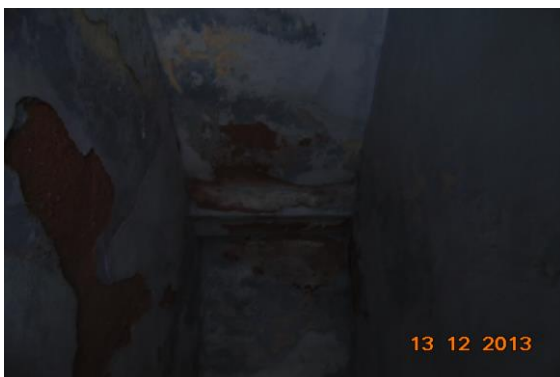
Photo 81

Peeling of Plaster on Wall No.4 & Roof of Store Under Stair Case of House No. 635, Ground Floor

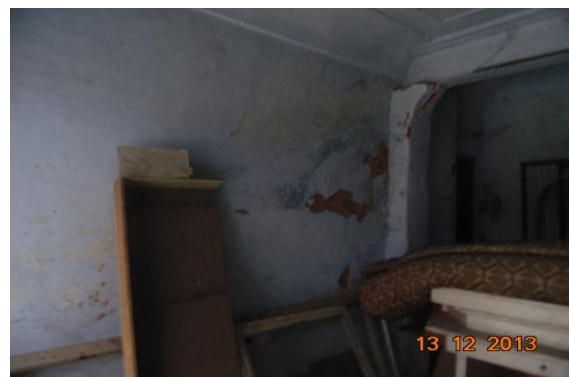
Photo 82

Dampness/Seepage on Wall No.4 & Roof of Vrandra of House No. 635, Ground Floor

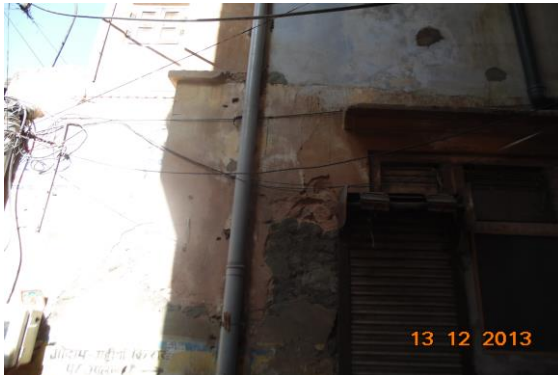
Photo 83

Peeling of Plaster of External Façade of Back Side Wall of House No. 635, Ground Floor

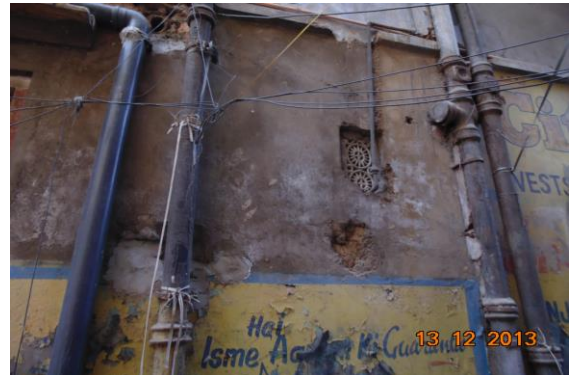
Photo 84

Damaged Portion of External Façade of Back Side Wall of House No. 635, Ground Floor

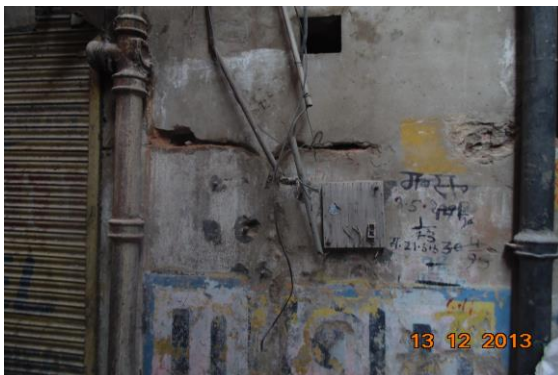
Photo 85

Damaged Portion of House No. 635 of Ground Floor

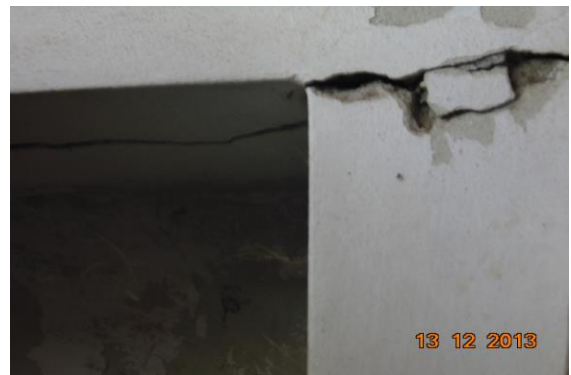
Photo 86

Peeling of Plaster of Hall No. 2 of Ground Floor
