Pre Building Condition Survey Report

Name and Address of Structure :	Choti Chopar to Badi Chopar (Down Line)
---------------------------------	---

Name of the Project	Contract JMRC-UG1B “Design and Construction of Tunnel between Chandpole and Badi Chouper and reverse line by Shield TBM, Underground Metro Stations at Choti Chouper and Badi Chouper by Cut and Cover Methods on East West Corridor of Jaipur Metro Rail Corporation Limited .”	
Owner :

Pre Building Condition Survey Report Choti Chopar to Badi Chopar (Down Line)

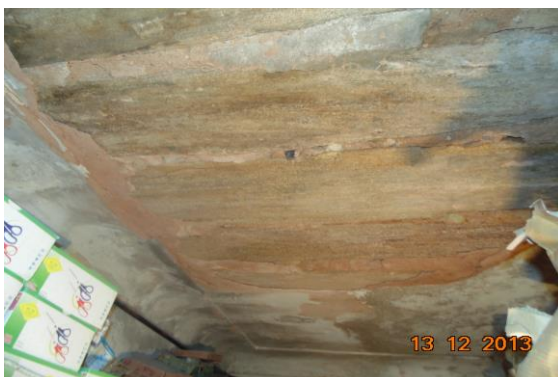
Photo 87

Dampness/Seepage on Roof of Room No. 9 of Ground Floor

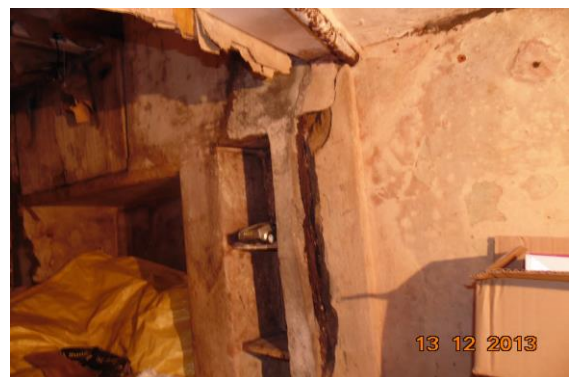
Photo 88

Dampness/Seepage on Roof of Room No. 9 of Ground Floor

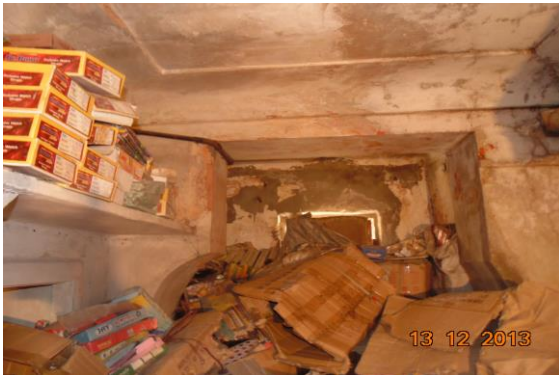
Photo 89
Peeling of Plaster of Room No. 9 of Ground Floor

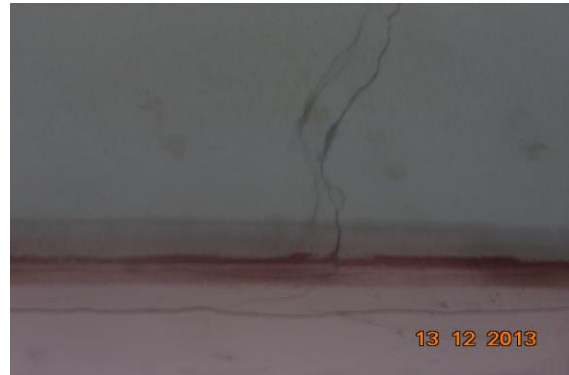
Photo 90
Damaged Portion of Hall No. 2 of Ground Floor

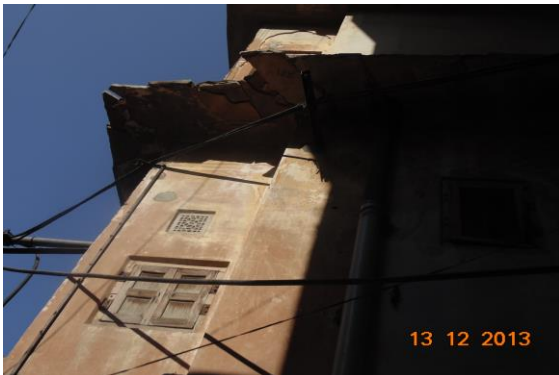
Photo 91
Damaged Portion on Back side Wall of External Façade of House No. 635, First Floor

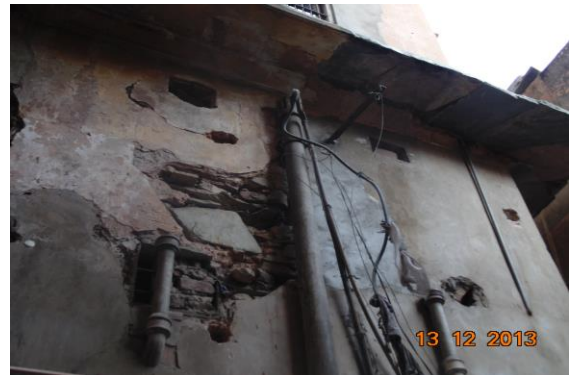
Photo 92
Dampness/Seepage on Right Side wall of External Façade of House No. 635, First Floor

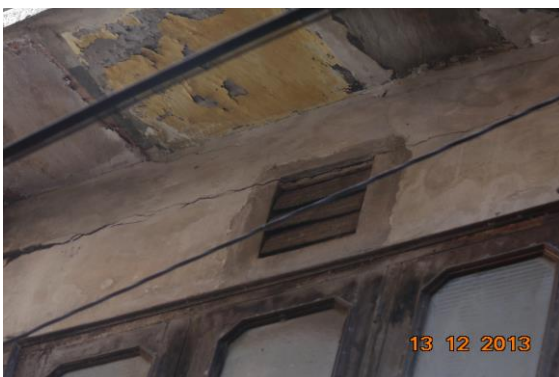
Photo 93
Peeling of Plaster on Front Side Wall of External Façade of House No. 635, First Floor

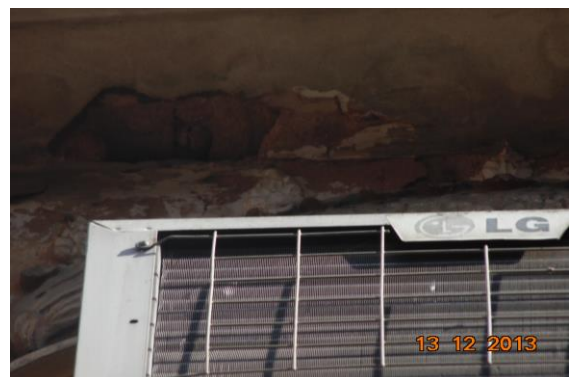
Photo 94
Damaged Portion on Front Side Wall & Shade of External Façade of House No. 635, First Floor

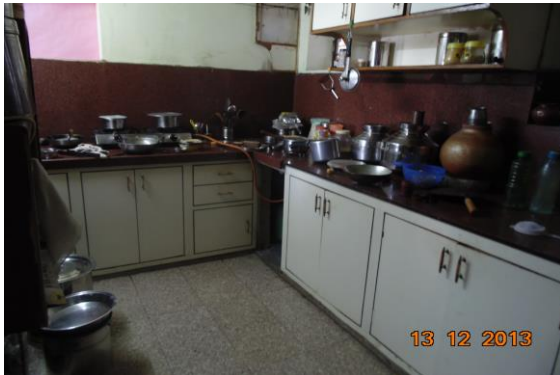
Photo 95

Dampness/Seepage on Front Side Wall & Shade of Room No. 3 of Second Floor

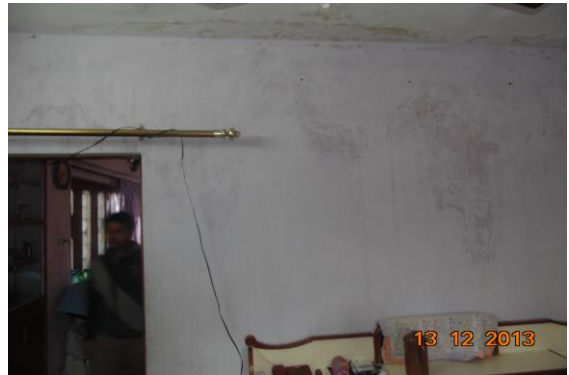
Photo 96

Dampness/Seepage on Roof of Room No. 3 of Second Floor

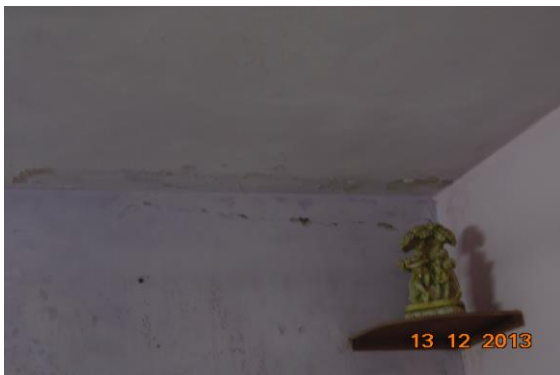
Photo 97

Peeling of Plaster of Room No. 3 of Second Floor

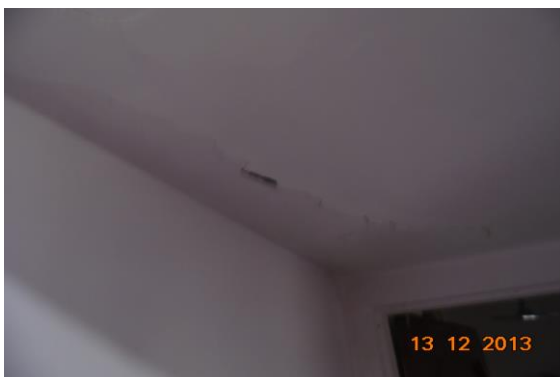
Photo 99

Plaster Crack of Passage of Toilet & Bathroom of House No. 635, Second Floor

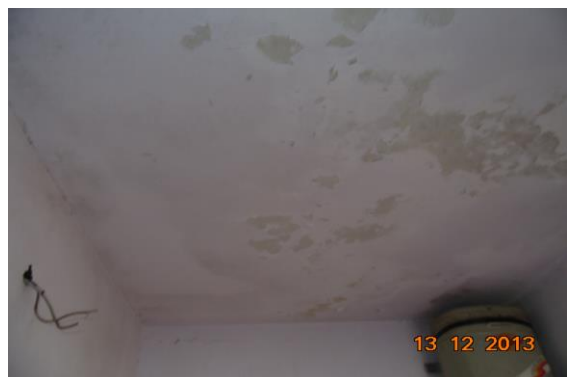
Photo 100

Dampness/Seepage on Roof of Toilet No. 2 of Second Floor

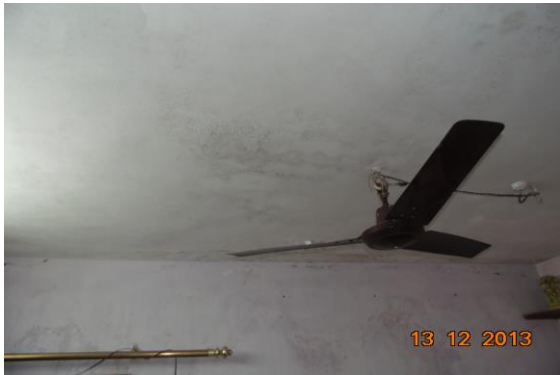
Photo 101
Dampness/Seepage on Roof of Room No. 3 of Second Floor

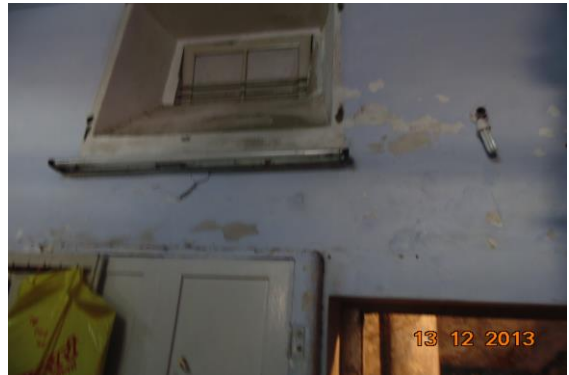
Photo 102
Peeling of Plaster on Roof of Room No. 4 of First Floor

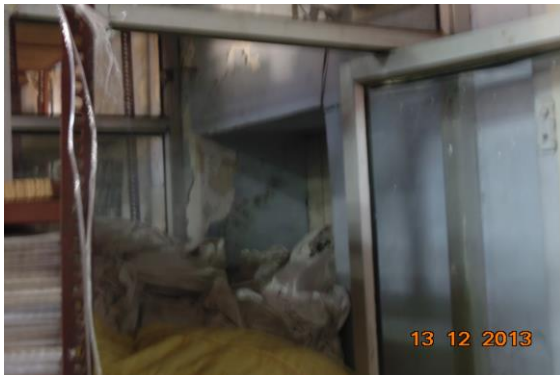
Photo 103
Peeling of Plaster on Roof of Room No. 4 of First Floor

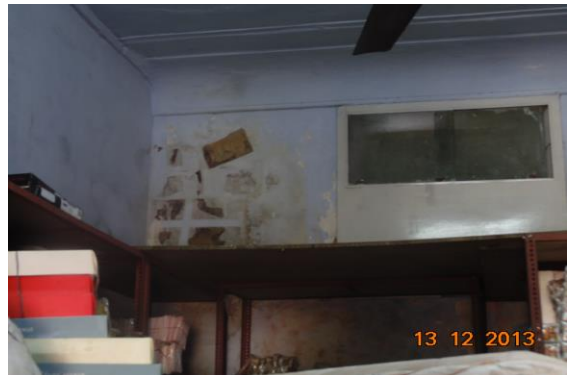
Photo 104
Dampness/Seepage on Roof of Room No. 4 of First Floor

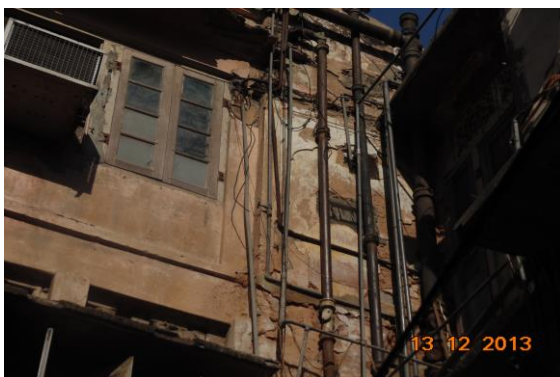
Photo 105
Damaged Portion on External Façade of House No. 635, First & Second Floor

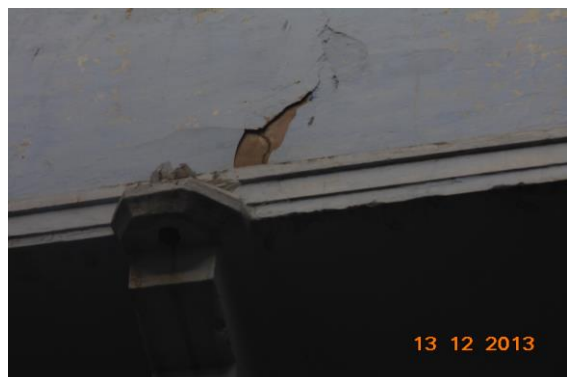
Photo 106
Peeling of Plaster on All Wall of Balcony of House No. 635, Second Floor

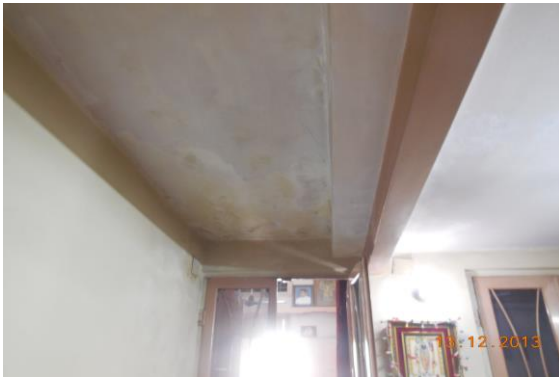
Photo 107

Dampness/Seepage on Roof of Dining Room of House No. 635, First Floor

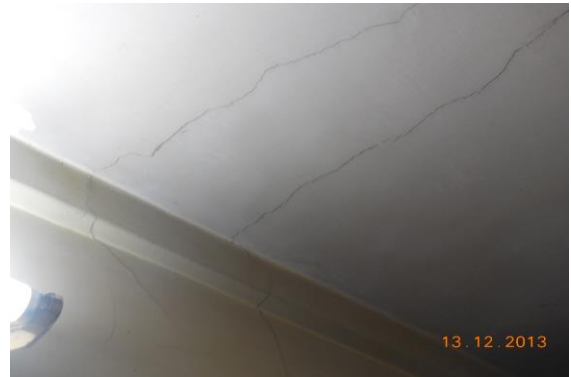
Photo 108

Plaster Crack on Wall No.4 & Roof of Kitchen of House No. 635, First Floor

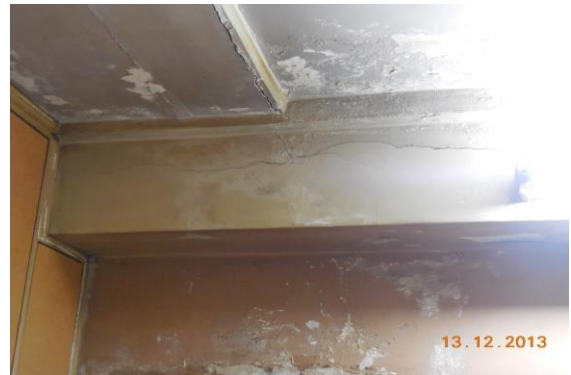
Photo 109

Dampness/Seepage on Roof of Kitchen of House No. 635, First Floor

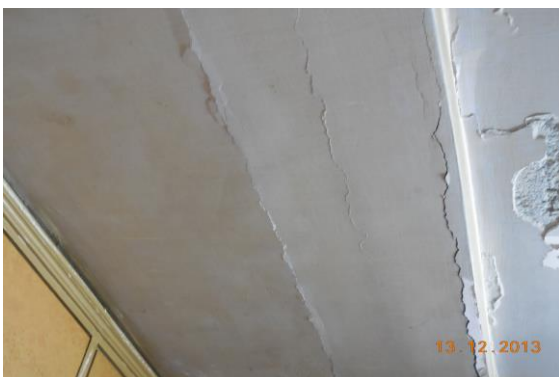
Photo 110

Damaged Portion on Wall No.4& Roof of Kitchen of House No. 635, First Floor

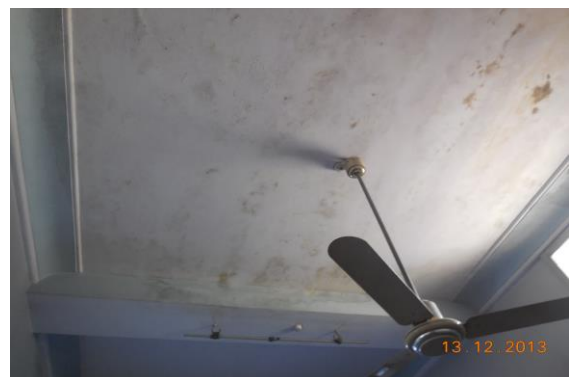
Photo 111

Damaged Portion on Roof of Kitchen of House No. 635, First Floor

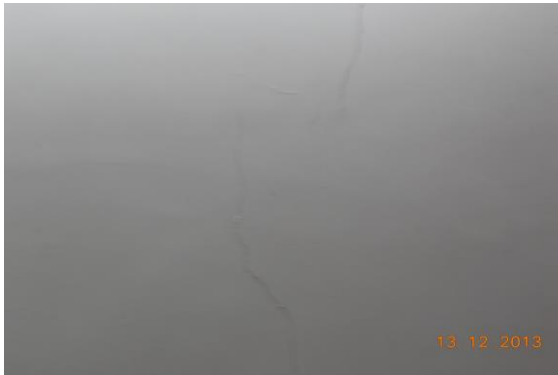
Photo 113
Plaster Crack on Roof of Room No. 2 of First Floor

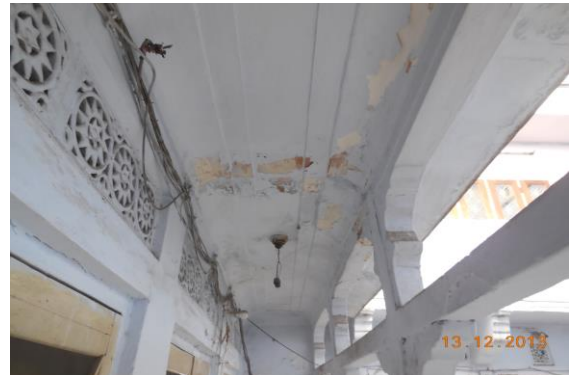
Photo 114
Peeling of Plaster on Roof of Balcony-4 of House No. 635, First Floor

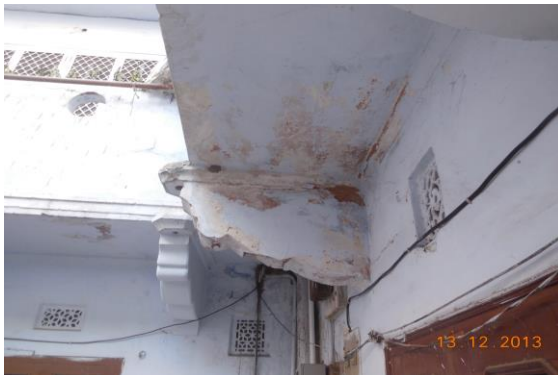
Photo 115
Dampness/Seepage on Roof of Balcony-3 of House No. 635, First Floor

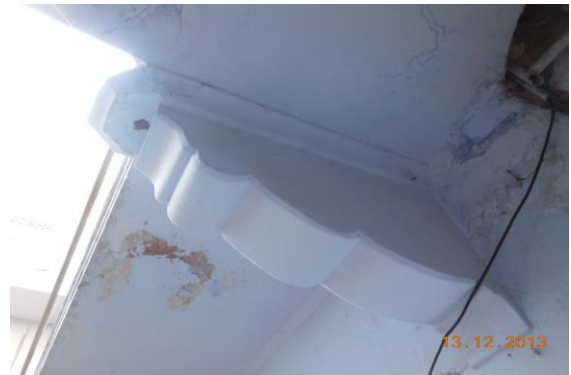
Photo 116
Peeling of Plaster on Roof of Balcony-3 of House No. 635, First Floor

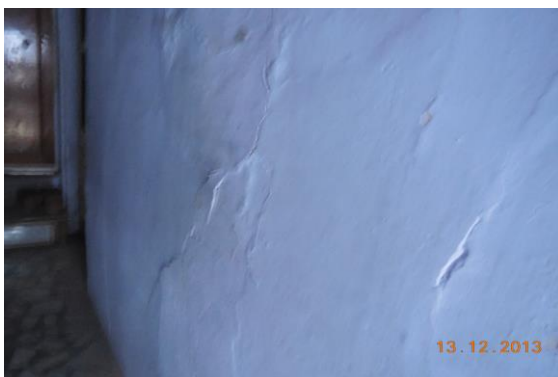
Photo 117
Peeling of Plaster on Roof of Passage-4 of House No. 635, First Floor

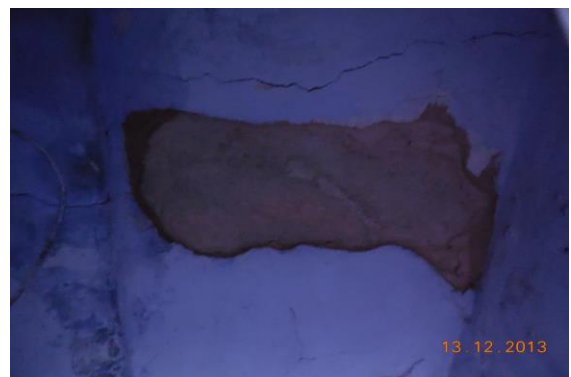
Photo 118
Peeling of Plaster on Roof of Passage-4 of House No. 635, First Floor

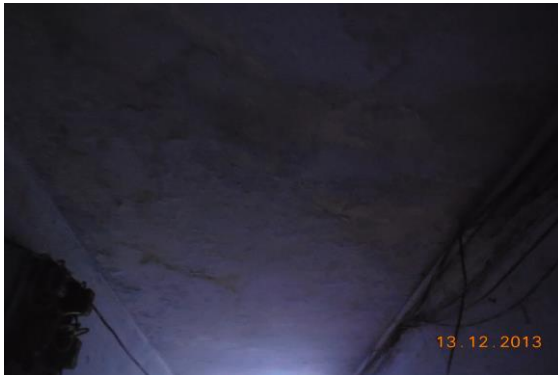
Photo 119
Dampness/Seepage on Roof of Passage-5 of House No. 635, First Floor

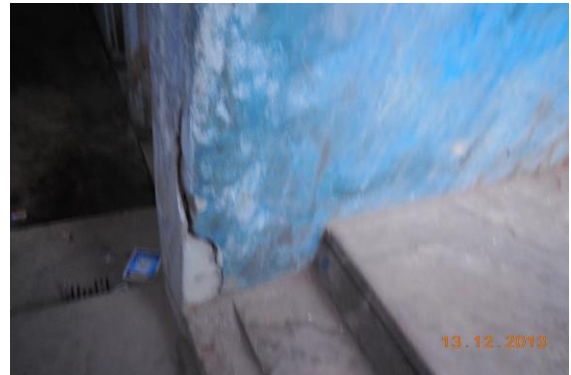
Photo 120
Damaged Portion on Roof of Stair of House No. 635, First Floor

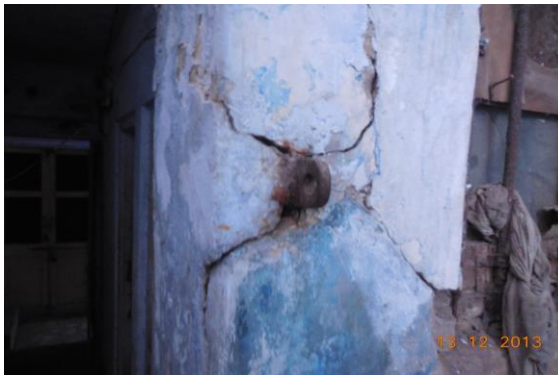
Photo 121
Damaged Portion on Roof of Stair of House No. 635, First Floor

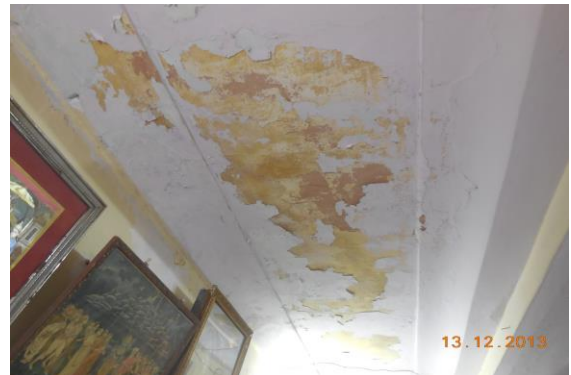
Photo 122
Dampness/Seepage on Roof of Hall No. 1 of Second Floor

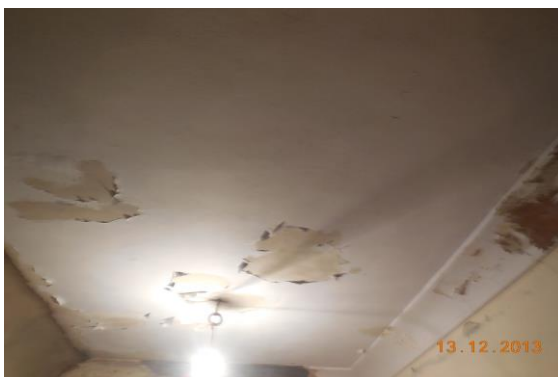
Photo 123
Peeling of Plaster on Roof of Room No. 7 of Second Floor

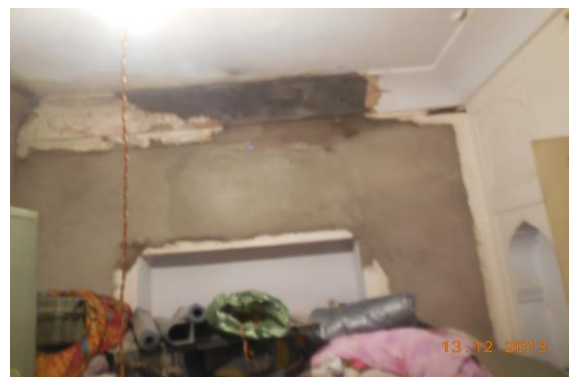
Photo 124
Peeling of Plaster on Roof of Room No. 8 of Second Floor

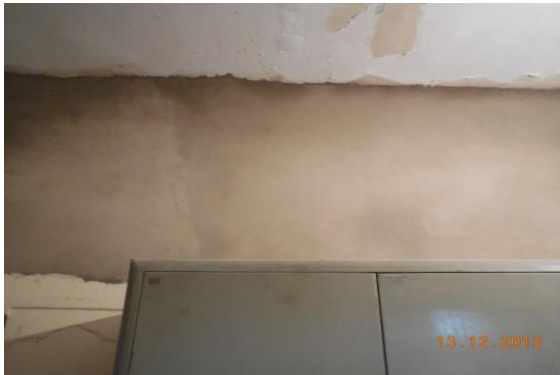
Photo 125

Peeling of Plaster on Roof of Room No. 8 of Second Floor

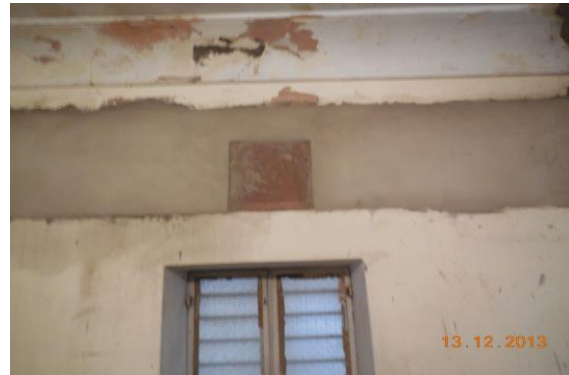
Photo 126

Peeling of Plaster on Roof of Room No. 1 of Second Floor

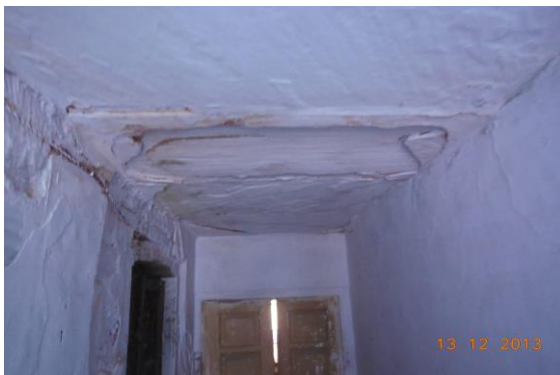
Photo 127

Peeling of Plaster of Gallery-1 of House No. 635, First Floor

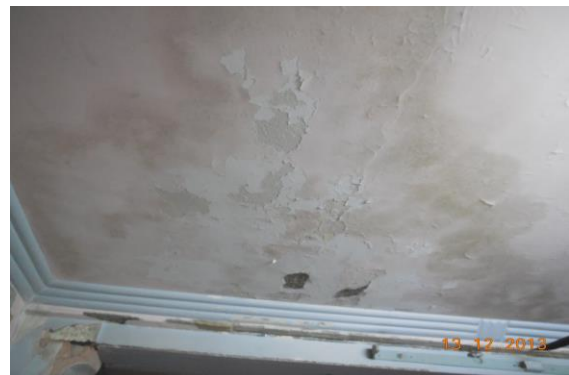
Photo 128

Peeling of Plaster on Roof of Hall No. 2 of Second Floor

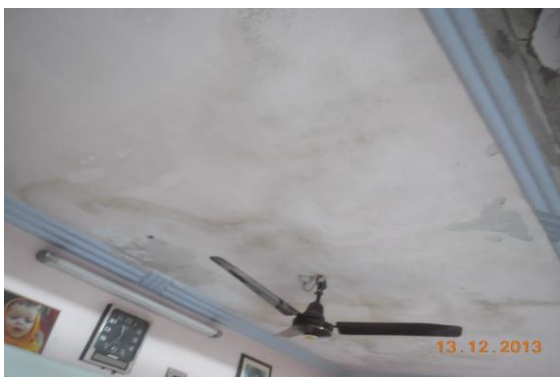
Photo 129

Peeling of Plaster of House No. 635 of Second Floor

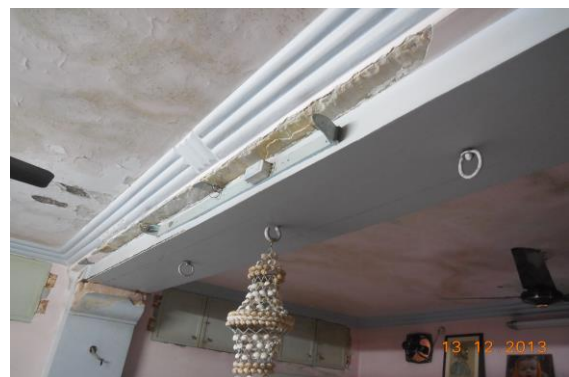
Photo 130

Damaged Portion on Beam of Hall No. 2 of Second Floor

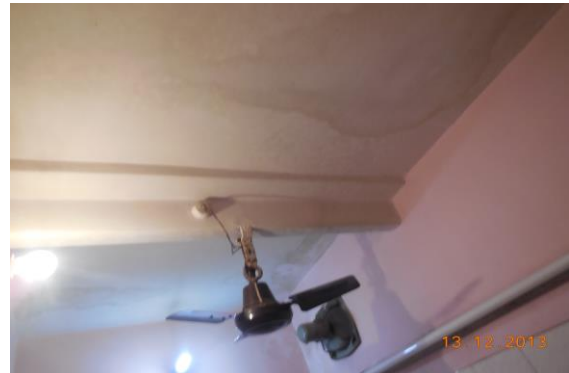
Photo 132
Dampness/Seepage on Roof of Toilet No. 1 of Second Floor

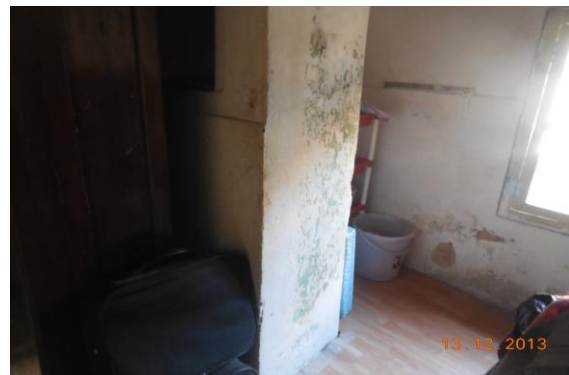
Photo 134
Peeling of Plaster on Floor of Store-1 of House No. 635, Second Floor

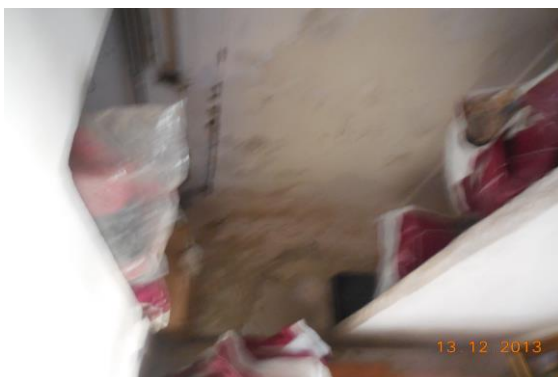
Photo 135
Dampness/Seepage on Wall No.1 & Roof of Store-1 of House No. 635, Second Floor

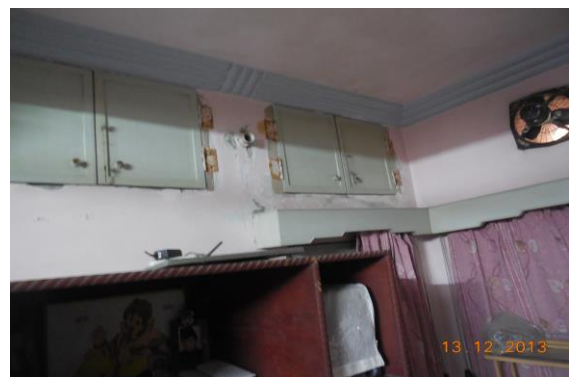
Photo 136
Peeling of Plaster on Floor of Hall No. 2 of Second Floor

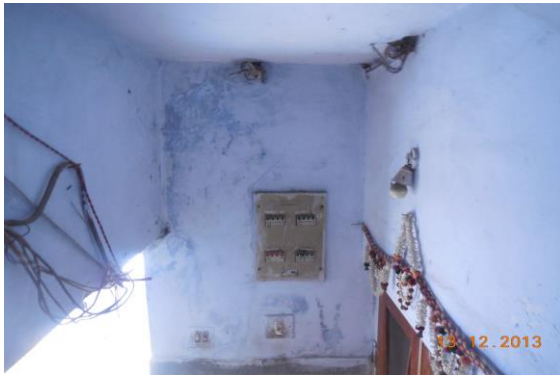
Photo 137

Dampness/Seepage on of Stair Case FF to SF of House No. 635, Second Floor

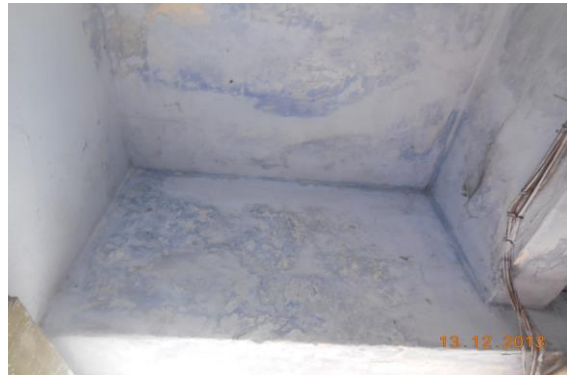
Photo 138

Dampness/Seepage on Wall No. Roof & 4 of Stair Case FF to SF of House No. 635, Second Floor

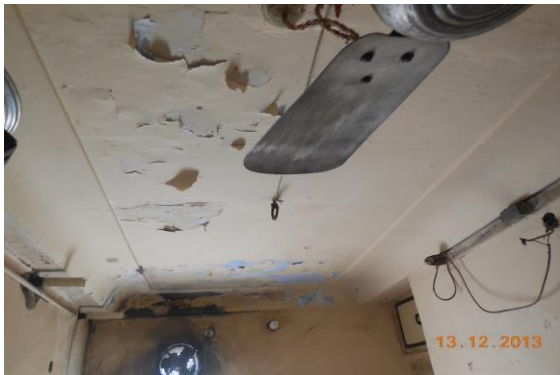
Photo 139

Peeling of Plaster on Roof of Kitchen-1 of House No. 635, Second Floor

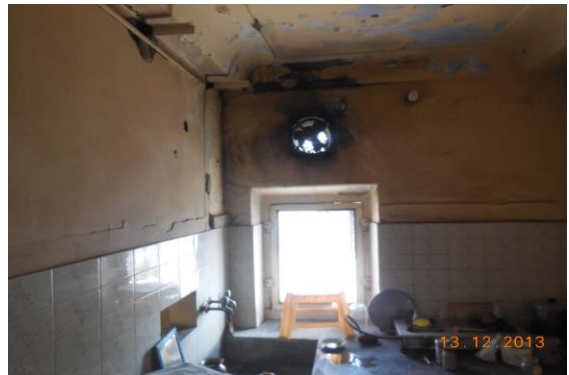
Photo 140

Dampness/Seepage on Roof of Kitchen-1 of House No. 635, Second Floor

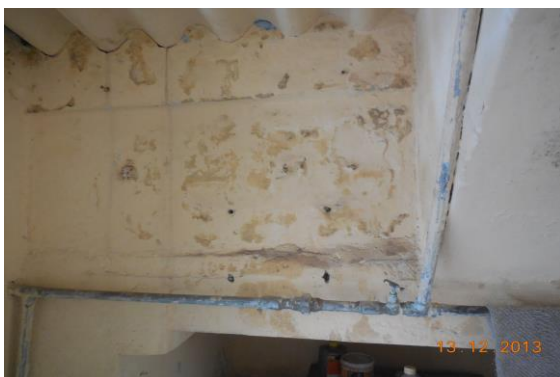
Photo 141

Dampness/Seepage on Roof of Kitchen-2 of House No. 635, Second Floor

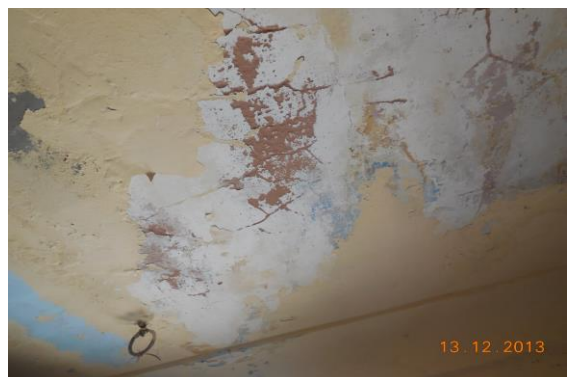
Photo 142

Peeling of Plaster on Roof of Temple of House No. 635, Second Floor

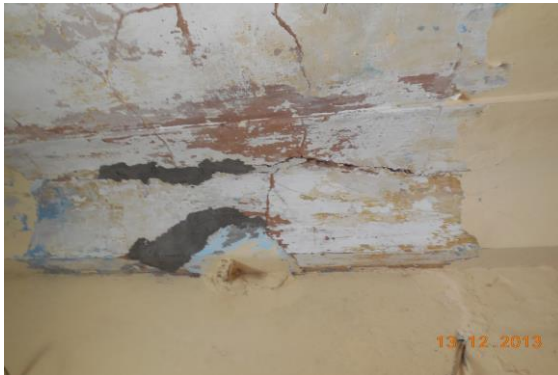
Photo 143
Peeling of Plaster on Roof of Temple of House No. 635, Second Floor

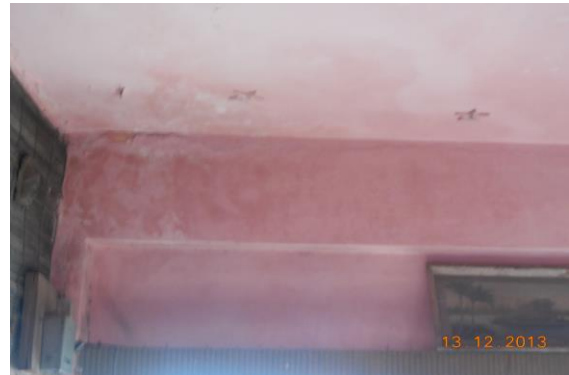
Photo 144
Dampness/Seepage on Wall No.4 & Roof of Room No. 4 of Second Floor

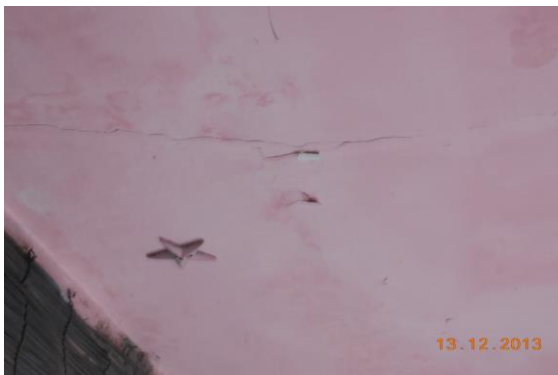
Photo 145
Plaster Crack on Roof of Room No. 4 of Second Floor

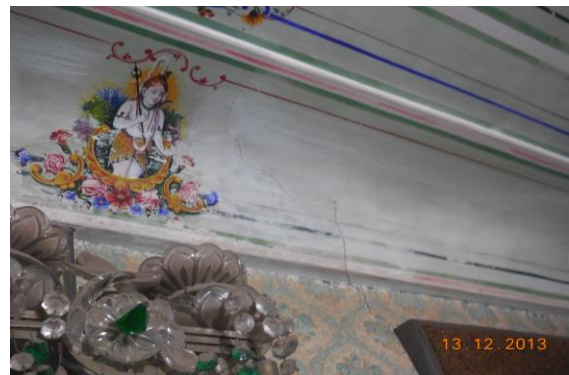
Photo 146
Plaster Crack on Roof of Room No. 3 of Second Floor

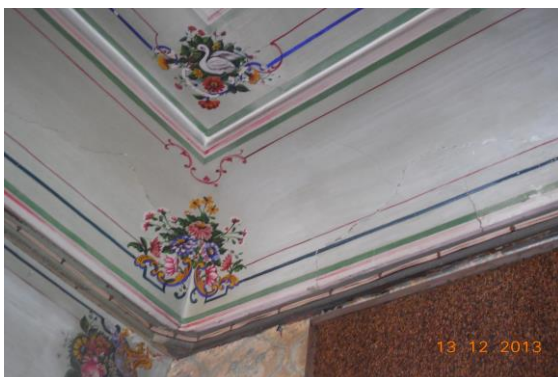
Photo 147
Peeling of Plaster on of House No. 635 of Second Floor

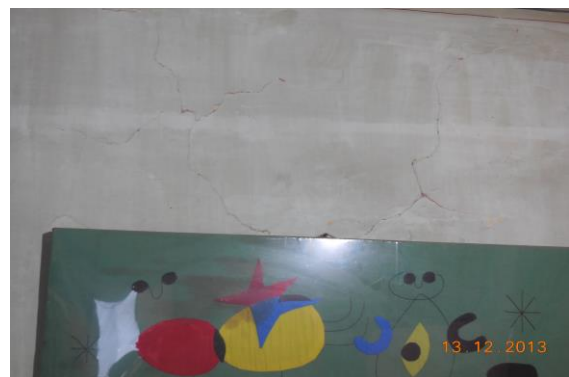
Photo 148
Plaster Crack on of Room No. 3 of Second Floor

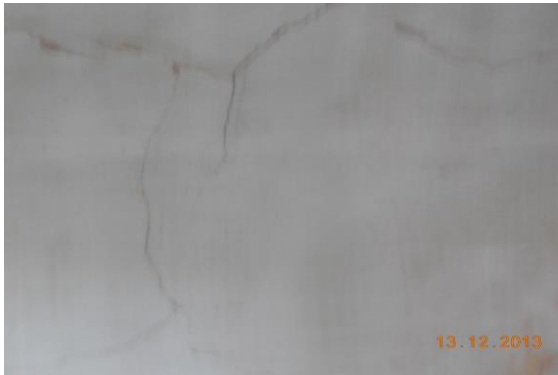
Photo 149
Plaster Crack on Room No. 3 of Second Floor

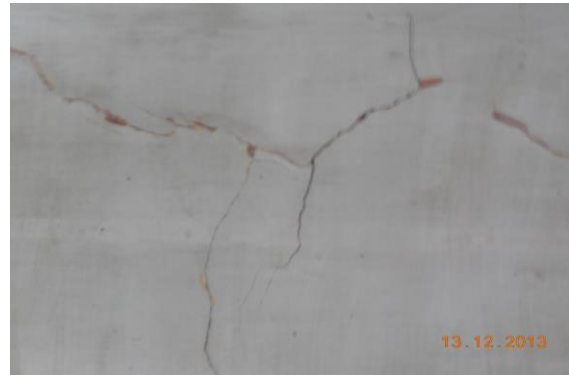
Photo 150
Plaster Crack on House No. 635 of Second Floor

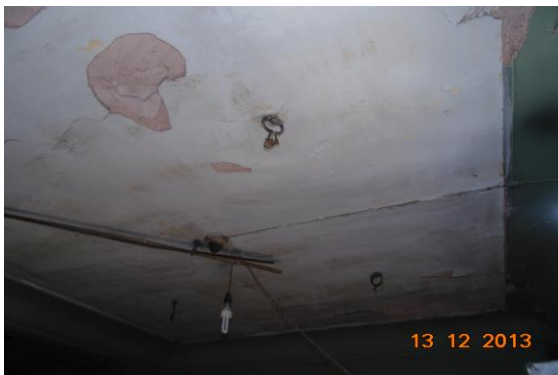
Photo 151
Damaged Portion on Roof of Room No. 11 of Second Floor

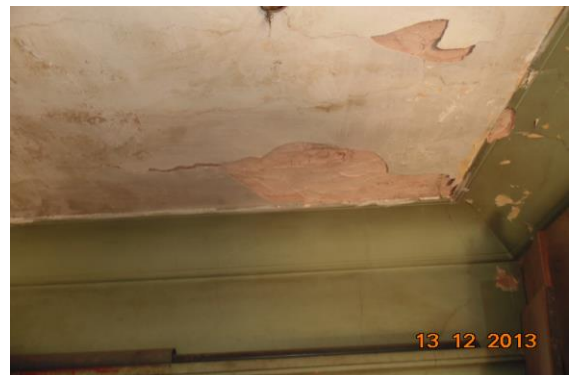
Photo 152
Damaged Portion of House No. 635 of Second Floor

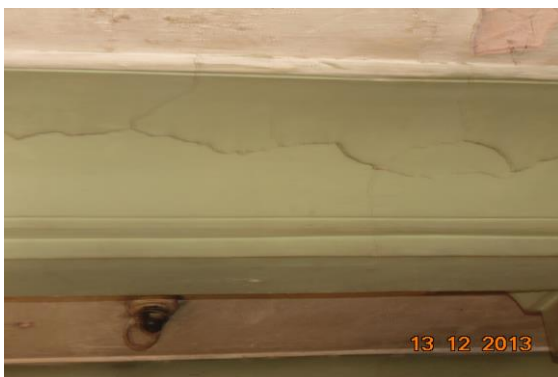
Photo 153
Damaged Portion on Roof of Room No. 11 of Second Floor

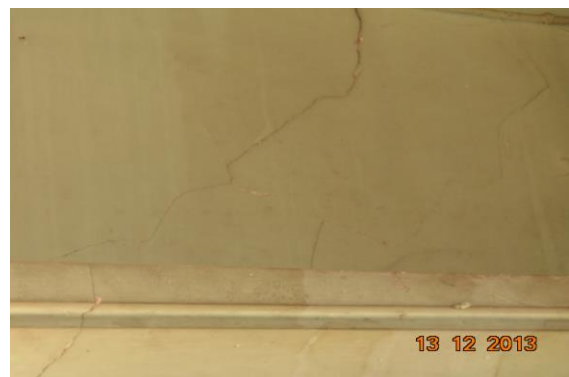
Photo 154
Damaged Portion on Roof of Room No. 11 of Second Floor

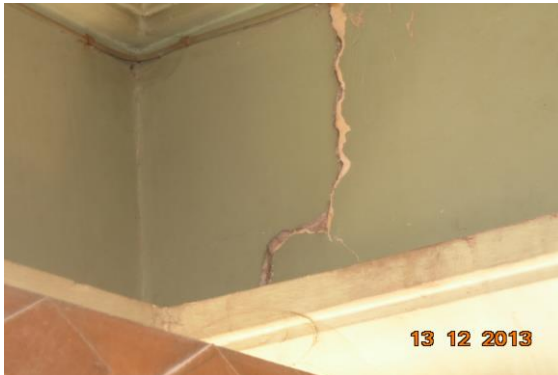
Photo 155
Damaged Portion on Roof of Room No. 11 of Second Floor

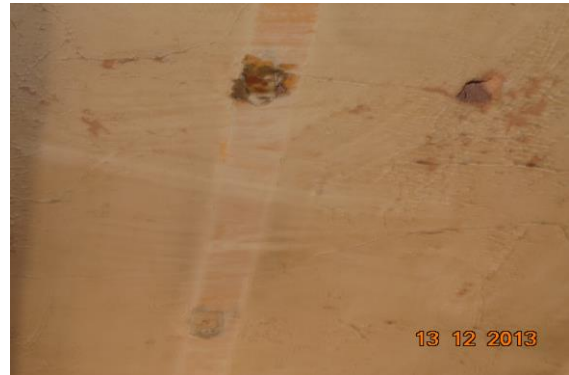
Photo 156
Dampness/Seepage on Roof of Room No. 11 of Second Floor

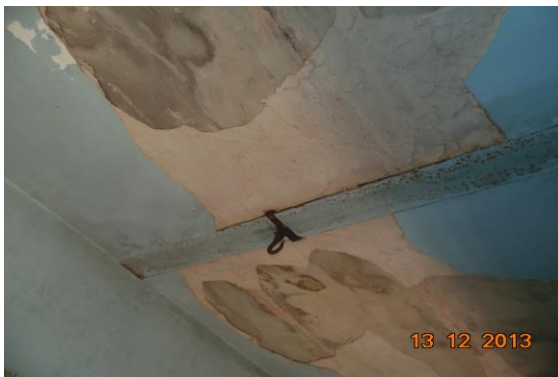
Photo 157
Peeling of Plaster on Roof of Room No. 12 of Second Floor

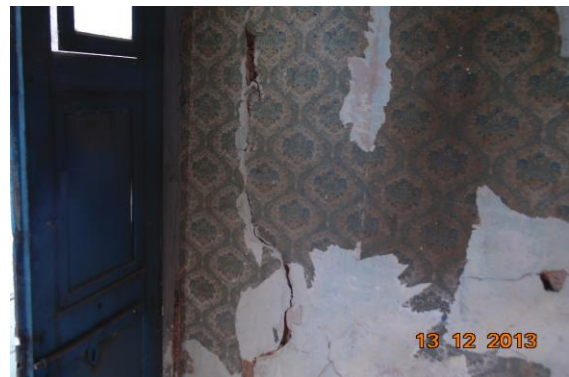
Photo 158
Damaged Portion on Roof of Room No. 12 of Second Floor

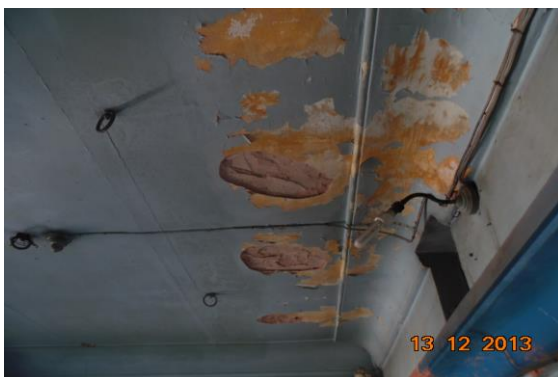
Photo 159
Peeling of Plaster on Roof of Room No. 13 of Second Floor

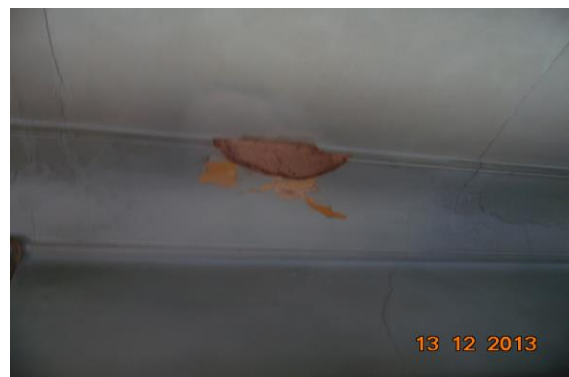
Photo 160
Peeling of Plaster on Roof of House No. 635 of Second Floor

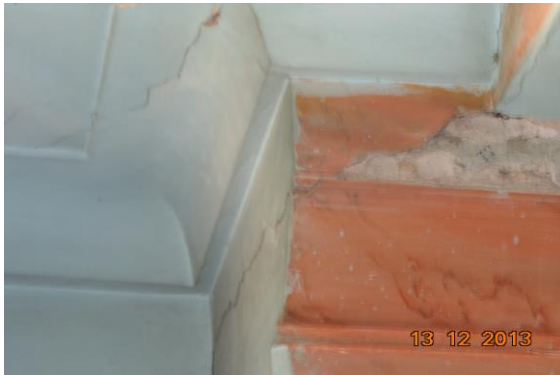
Photo 161

Damaged Portion on Wall No. 2 & Roof of Room No. 13 of Second Floor

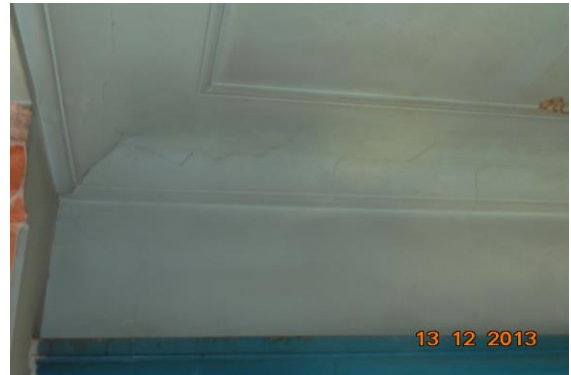
Photo 162

Damaged Portion on Wall No. 2 & Roof of Room No. 13 of Second Floor

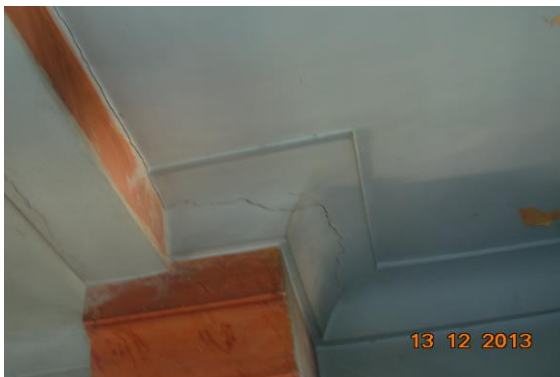
Photo 163

Damaged Portion on Wall No.1 & Roof of Room No. 13 of Second Floor

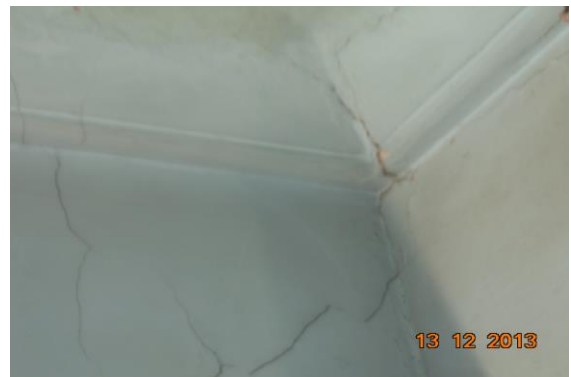
Photo 164

Damaged Portion on Wall No. 1 & Roof of Room No. 13 of Second Floor

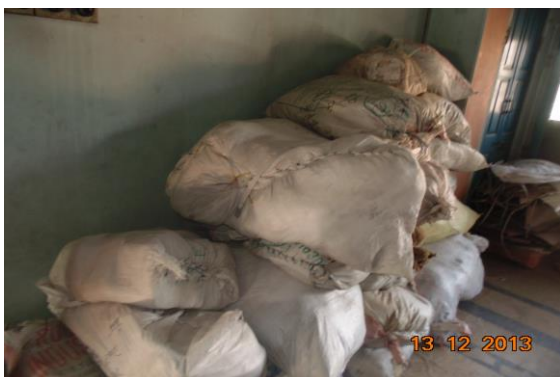
Photo 165

Dampness/Seepage on Wall No.3& Roof of Lobby of House No. 635, Third Floor

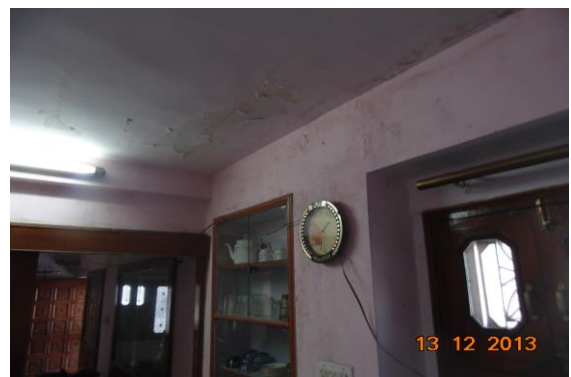
Photo 166

Dampness/Seepage on Wall No.2,4 & Roof, of Lobby of House No. 635, Third Floor

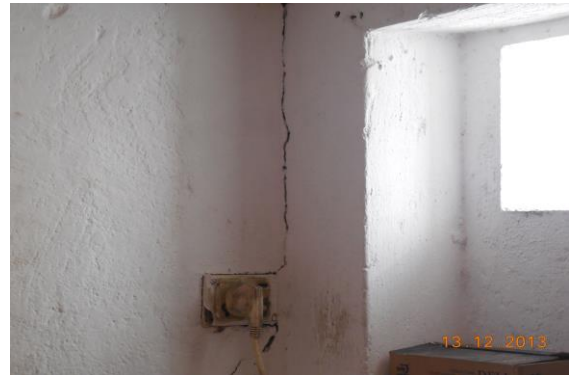
Photo 168
Damaged Portion of Room No. 6 of Second Floor

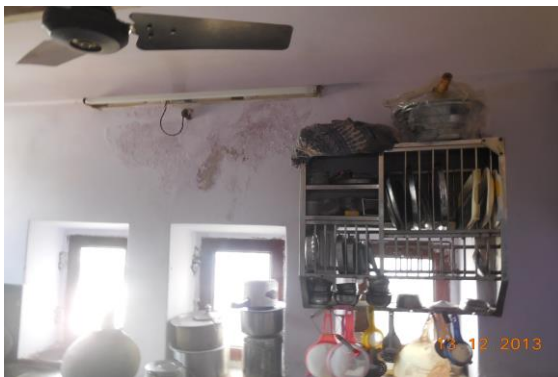
Photo 169
Dampness/Seepage on Outer Wall of Kitchen of House No. 635, Second Floor

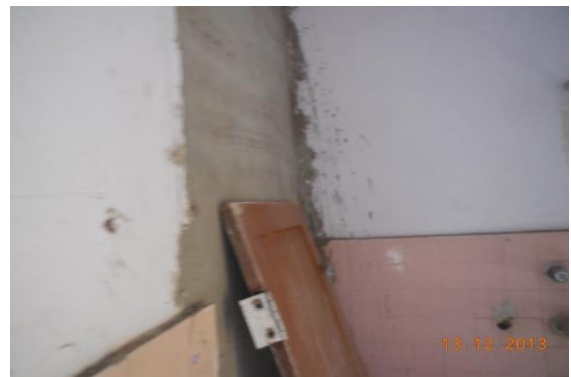
Photo 170
Peeling of Plaster on Outer Wall of Store of House No. 635, Second Floor

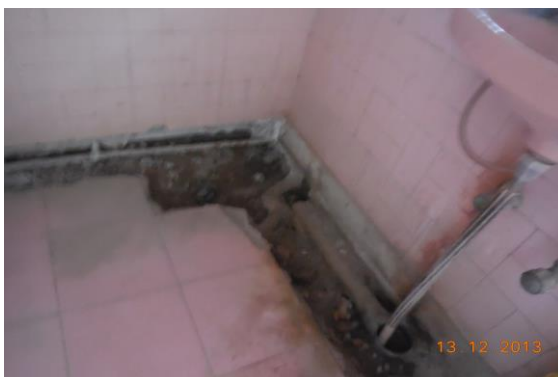
Photo 171
Peeling of Plaster on Store of House No. 635, Second Floor

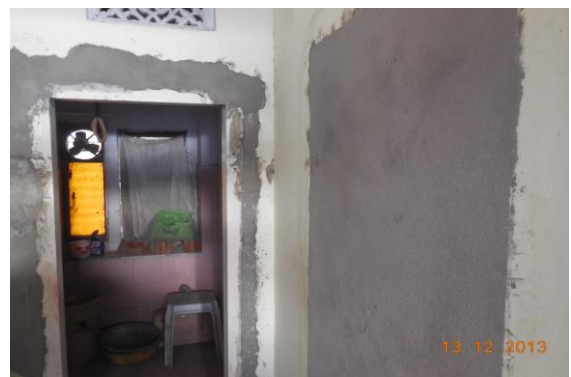
Photo 172
Peeling of Plaster on All Wall of Passage of House No. 635, Second Floor

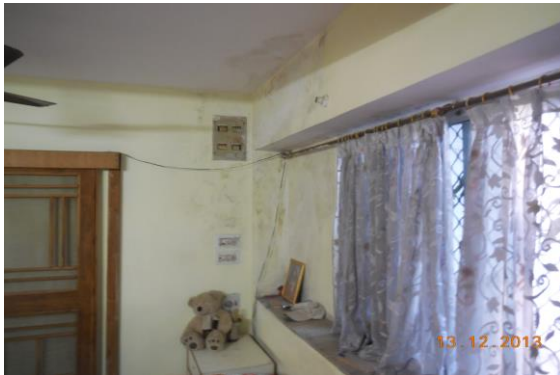
Photo 173

Dampness/Seepage on All Wall of Room No. 10 of Second Floor

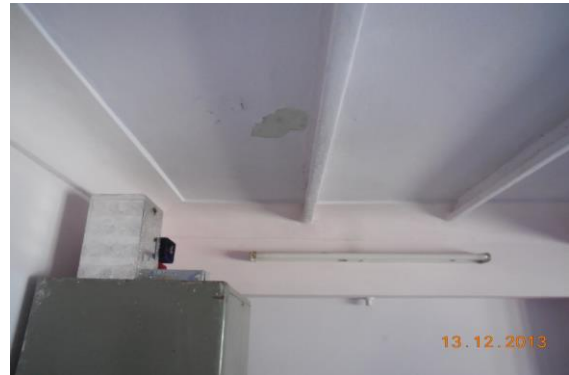
Photo 174

Peeling of Plaster on Roof of Room No. 11 of Second Floor

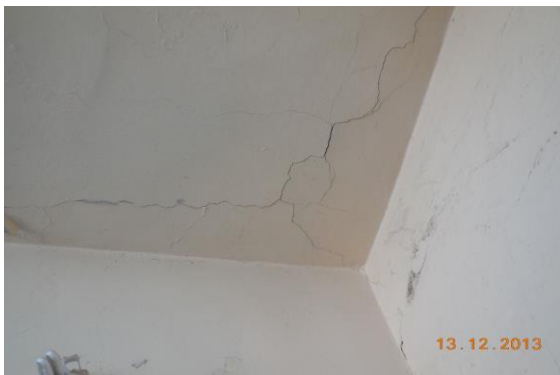
Photo 175

Peeling of Plaster on Roof of Balcony Shade of House No. 635, Third Floor

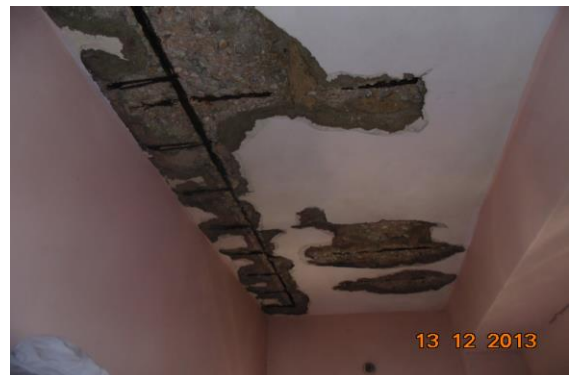
Photo 176

Exposed Reinforcement on Roof of Toilet No. 1 of Third Floor

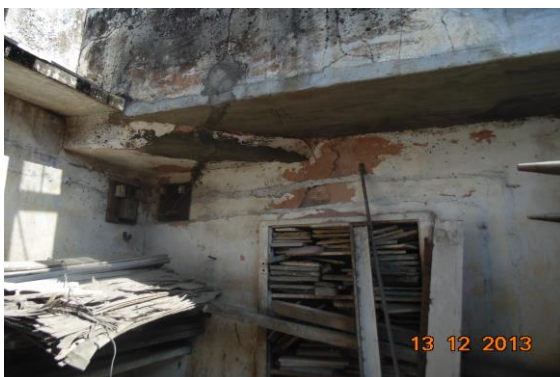
Photo 177

Peeling of Plaster on Wall No.2 & Sunshade of Sky Open Lobby of House No. 635, Second Floor

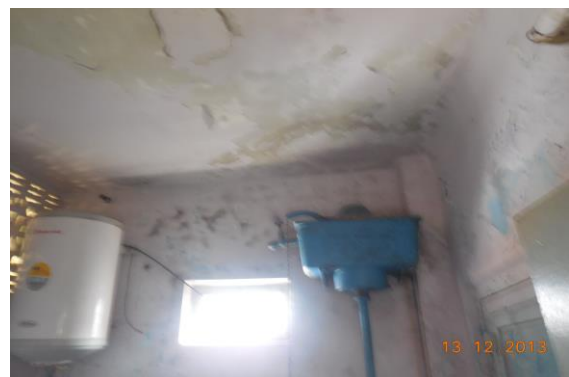
Photo 178

Dampness/Seepage on Roof of Toilet No. 1 of Third Floor

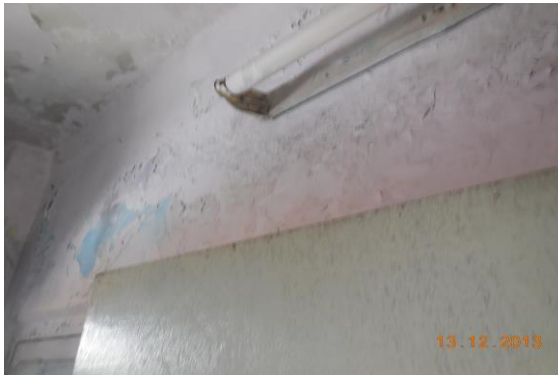
Photo 179
Dampness/Seepage on Roof of Toilet No. 1 of Third Floor

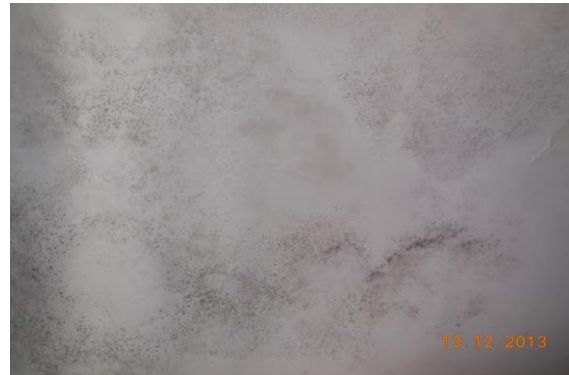
Photo 180
Dampness/Seepage on Roof of Lobby of House No. 635, Third Floor

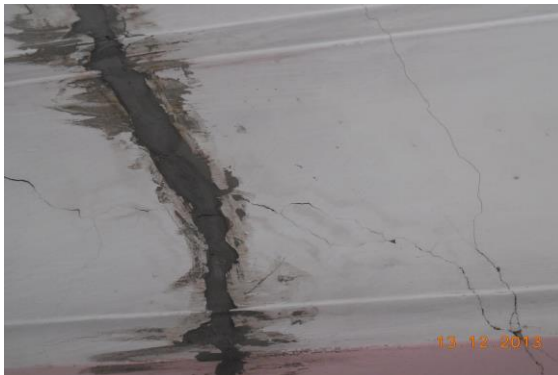
Photo 181
Plaster Crack on Wall No.2 & Roof of Room No. 5 of Second Floor

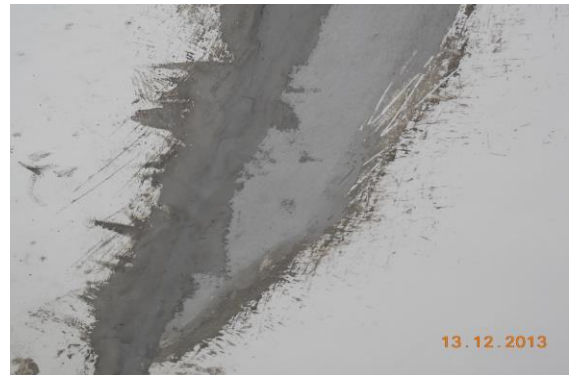
Photo 182
Peeling of Plaster on Roof of Room No. 5 of Second Floor

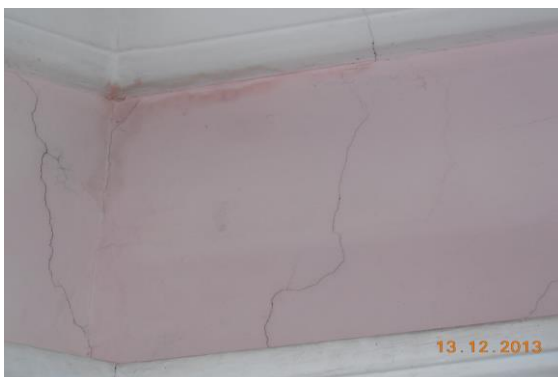
Photo 183
Plaster Crack on Wall No.1,3 & Roof, of Room No. 5 of Second Floor

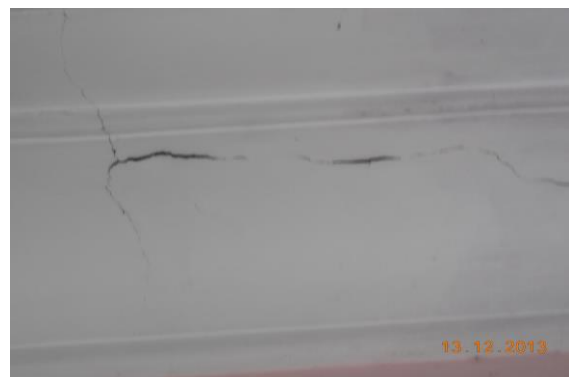
Photo 184
Peeling of Plaster on Roof of Room No. 5 of Second Floor

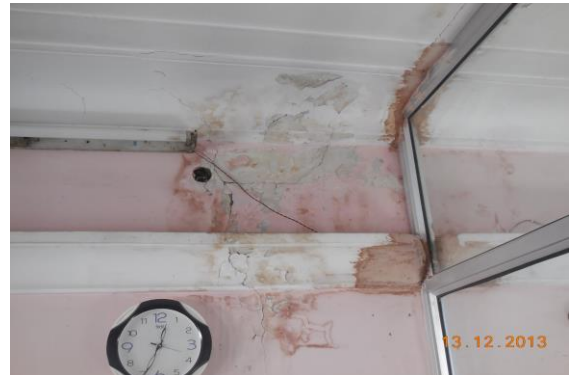
Photo 186
Peeling of Plaster on Wall No.2& Roof of Room No. 5 of Second Floor

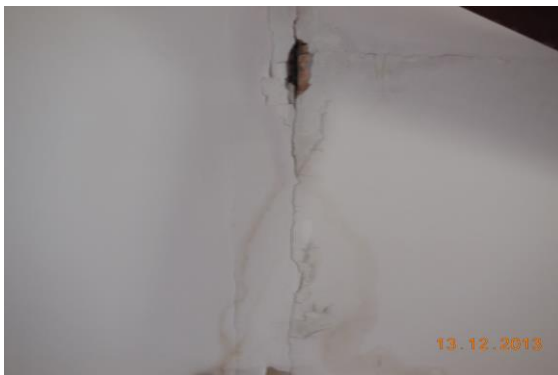
Photo 187
Peeling of Plaster on Roof of Room No. 5 of Second Floor

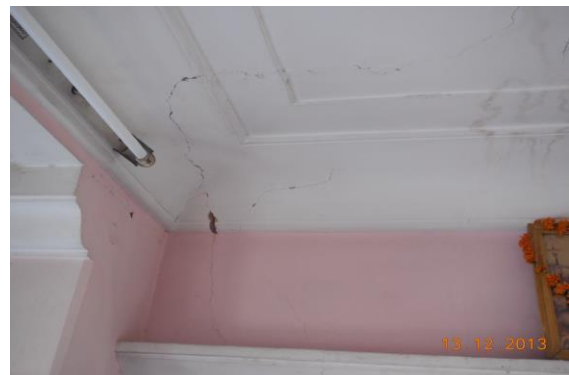
Photo 188
Peeling of Plaster of House No. 635 of Second Floor

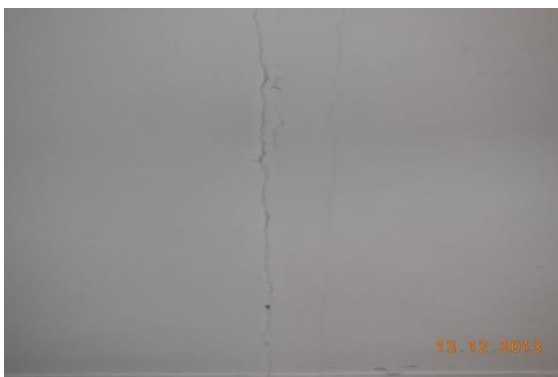
Photo 189
Damaged Portion on Roof of Room No. 5 of Second Floor

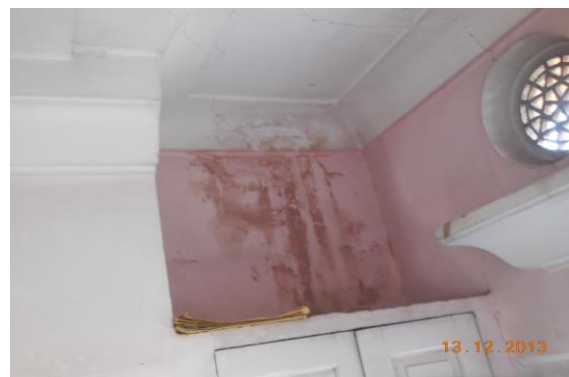
Photo 190
Dampness/Seepage on Wall No.1 & Roof of Room No. 5 of Second Floor

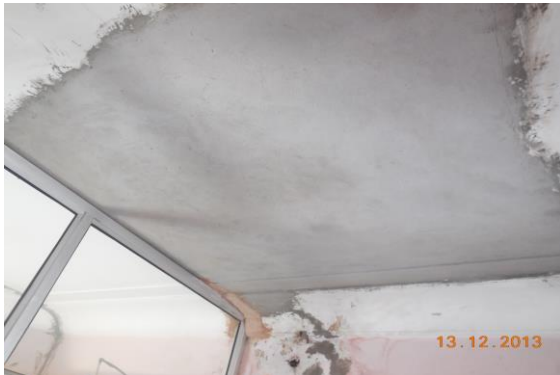
Photo 191

Peeling of Plaster on Roof of Room No. 5 of Second Floor
