Pre Building Condition Survey Report

Name and Address of Structure :	Choti Chopar to Badi Chopar (Down Line)
---------------------------------	---

Name of the Project	Contract JMRC-UG1B “Design and Construction of Tunnel between Chandpole and Badi Chouper and reverse line by Shield TBM, Underground Metro Stations at Choti Chouper and Badi Chouper by Cut and Cover Methods on East West Corridor of Jaipur Metro Rail Corporation Limited .”	
Owner :

Pre Building Condition Survey Report Choti Chopar to Badi Chopar (Down Line)

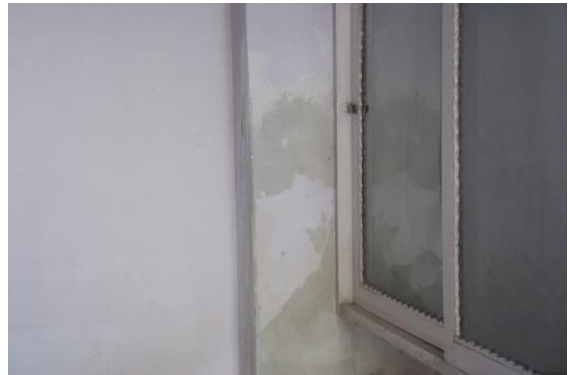
Photo 192

Peeling of Plaster on Wall No. 4 of Shop No.254 of Ground Floor

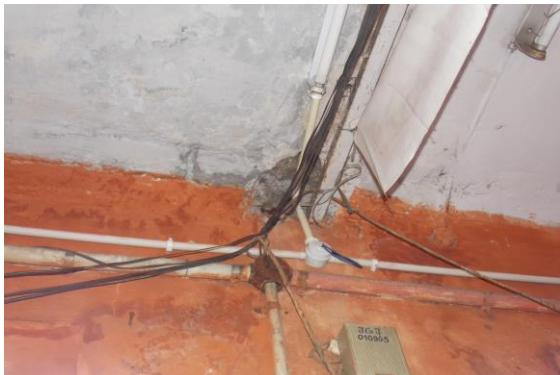
Photo 193

Damaged Portion on Roof of Varanda of Shop No.254 of Ground Floor

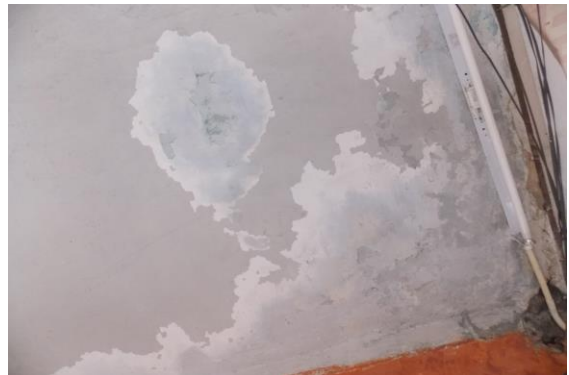
Photo 194

Dampness/Seepage on Roof of Varanda of Shop No.254 of Ground Floor

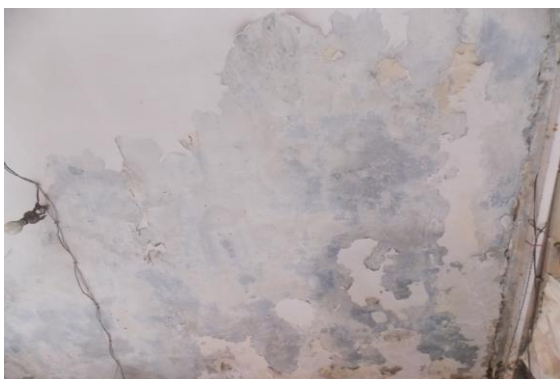
Photo 195

Dampness/Seepage on Roof of Varanda of Shop No.253 of Ground Floor

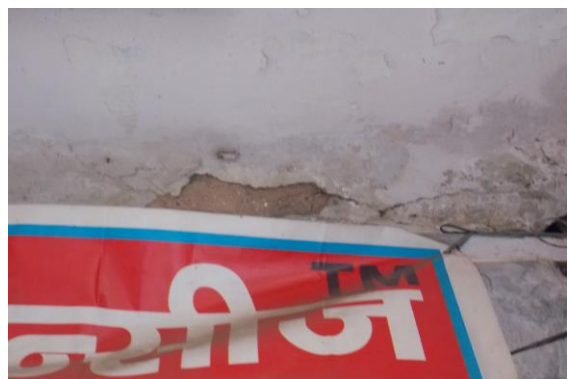
Photo 196

Dampness/Seepage of Varanda of Shop No.253 of Ground Floor

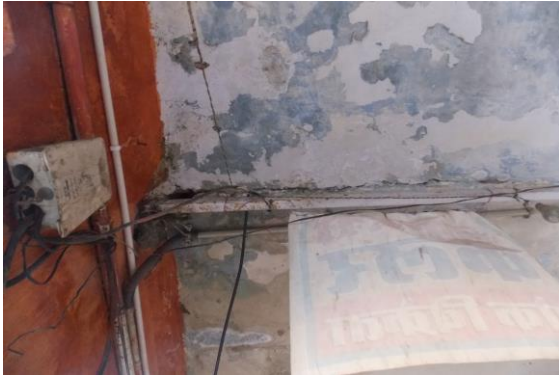
Photo 197

Damaged Portion on Roof of Varanda of Shop No.254 of Ground Floor

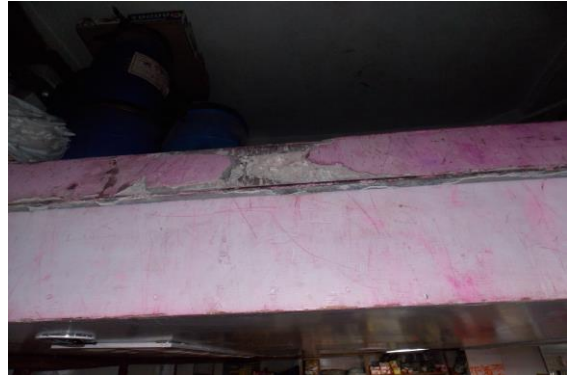
Photo 198

Dampness/Seepage on Roof of Shop No.252 of Ground Floor

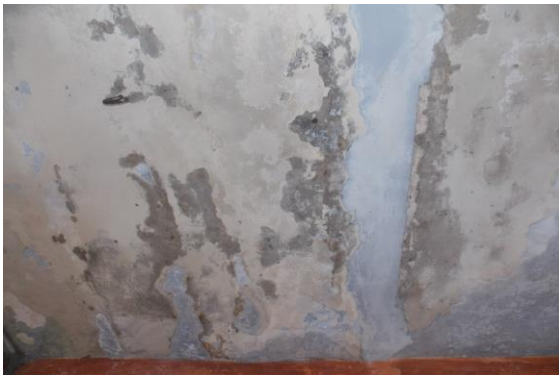
Photo 199

Dampness/Seepage on Wall No. R of Varanda of Shop No.252 of Ground Floor

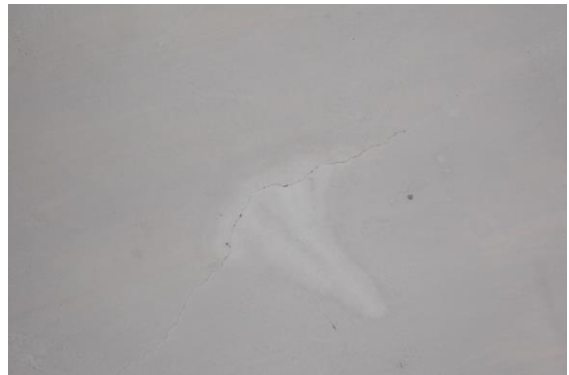
Photo 200

Plaster Crack on Roof of Varanda of Shop No.250 of Ground Floor

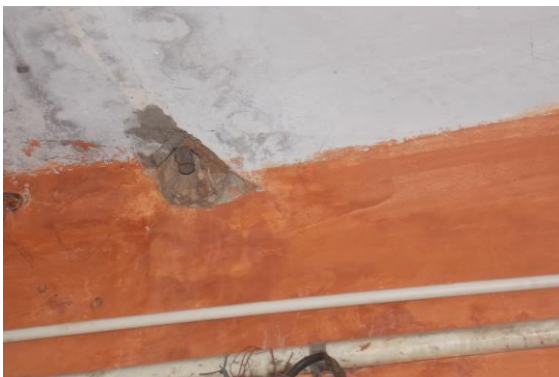
Photo 201

Damaged Portion on Roof of Varanda of Shop No.250 of Ground Floor

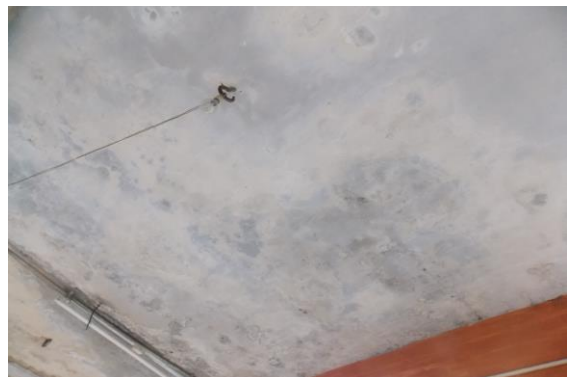
Photo 202

Dampness/Seepage on Roof of Varanda of Shop No.251 of Ground Floor

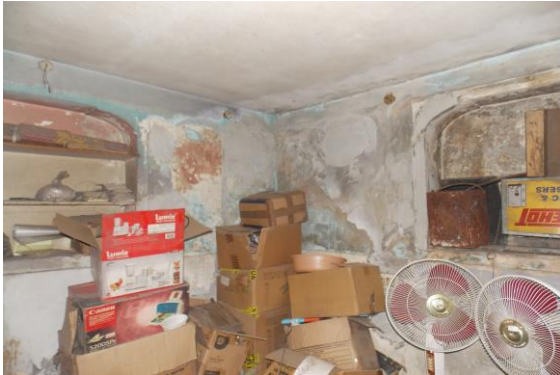
Photo 203

Dampness/Seepage on Wall No. 2 & 4 of Shop No.248 of Ground Floor

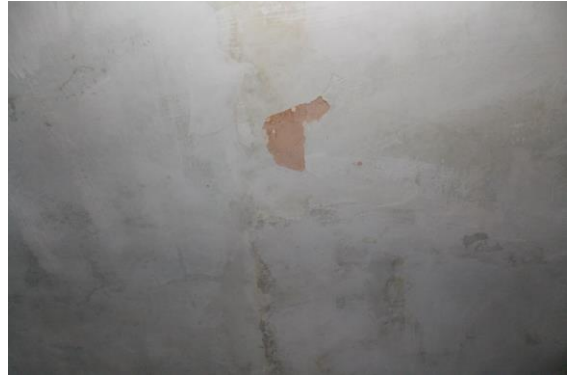
Photo 204

Peeling of Plaster on Roof of Shop No.248 of Upper Ground Floor

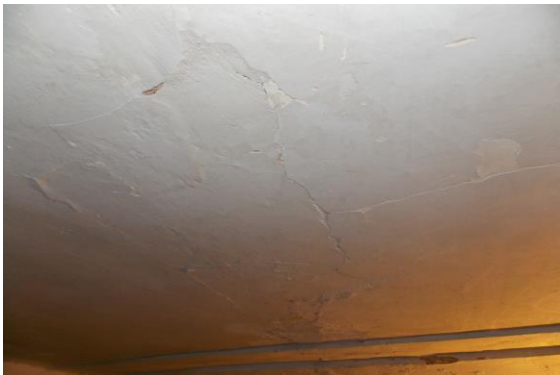
Photo 205

Peeling of Plaster of Shop No.248 of Upper Ground Floor

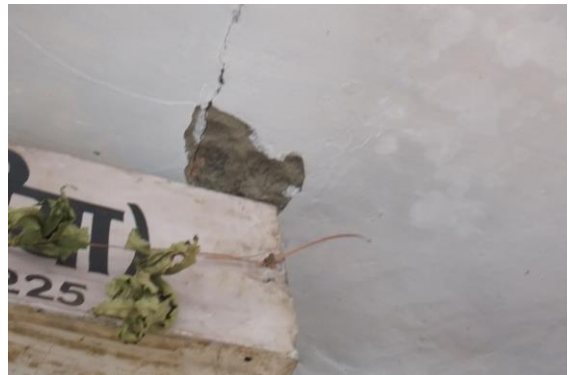
Photo 206

Peeling of Plaster on Roof of Varanda of Shop No.248 of Ground Floor

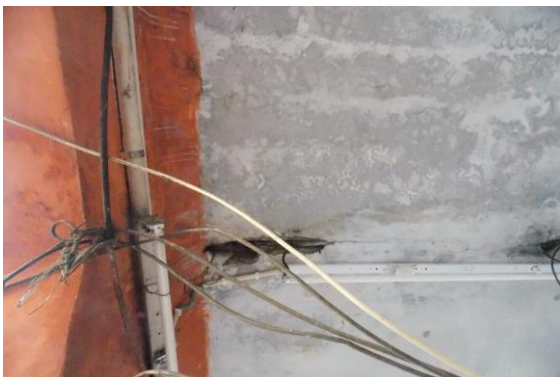
Photo 207

Damaged Portion on Roof of Varanda of Shop No.248 of Ground Floor

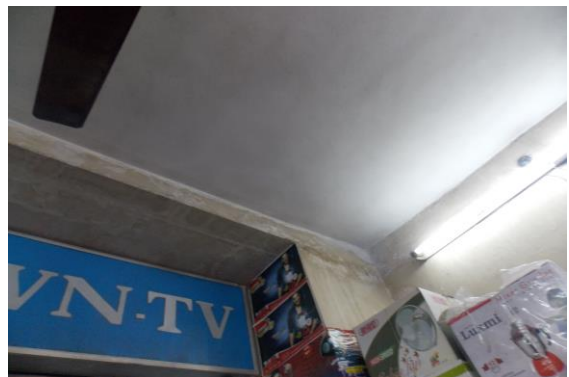
Photo 208

Dampness/Seepage on Wall No.2 & Roof of Shop No.247 of Ground Floor

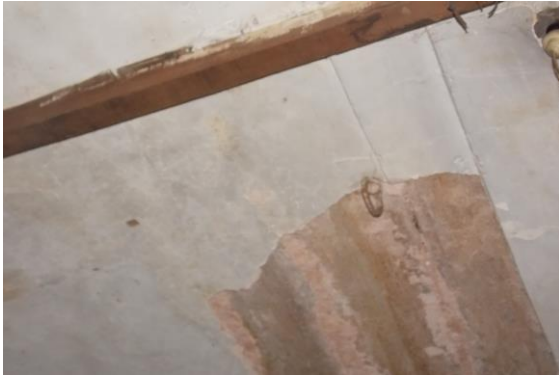
Photo 209

Damaged Portion on Roof of Shop No.247 of Upper Ground Floor

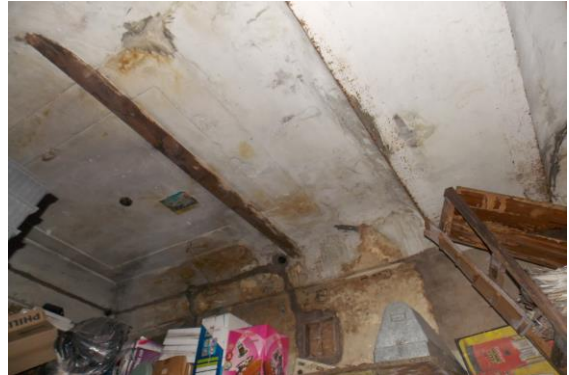
Photo 210

Damaged Portion of Shop No.247 of Upper Ground Floor

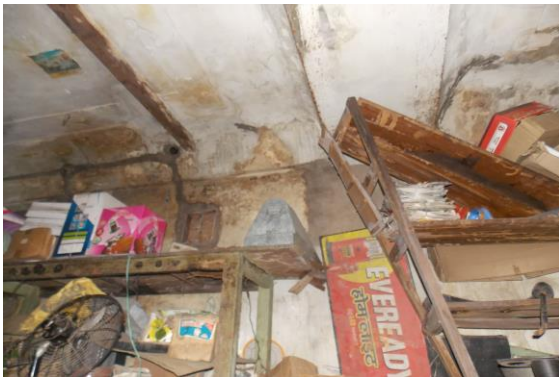
Photo 211

Dampness/Seepage on Wall No. 1 of Shop No.247 of Upper Ground Floor

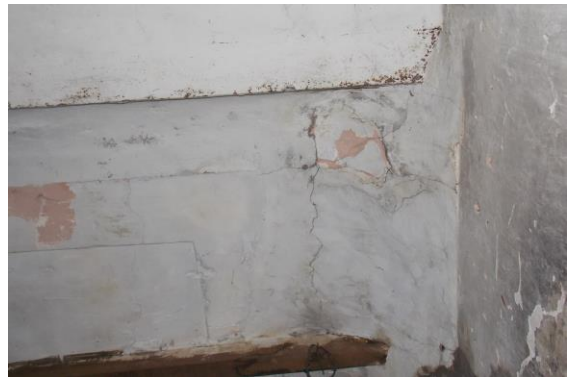
Photo 212

Damaged Portion on Roof of Shop No.247 of Upper Ground Floor

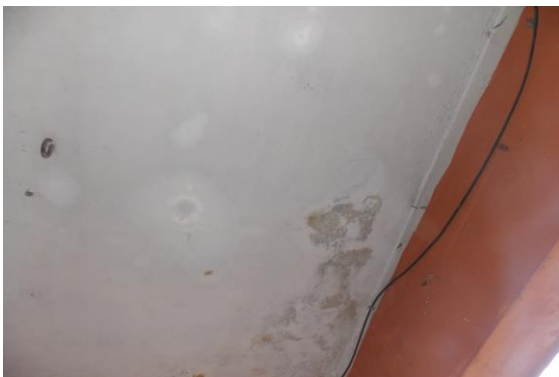
Photo 213

Dampness/Seepage on Roof of Varanda of Shop No.247 of Ground Floor

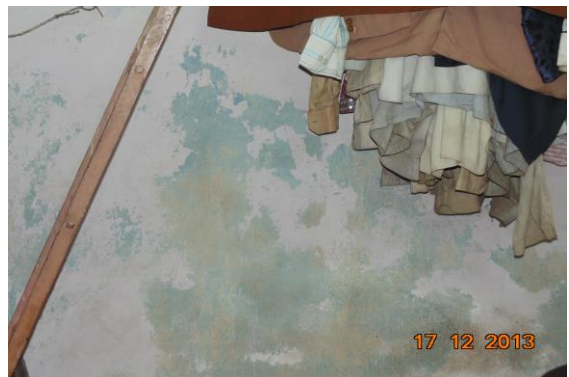
Photo 214

Peeling of Plaster on Wall No. 4 of Shop Ra Rafugar of Ground Floor

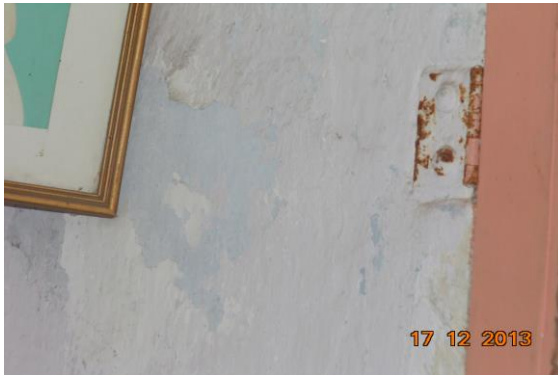
Photo 215
Peeling of Plaster on Wall No. 2 of Shop Ra Rafugar of Ground Floor

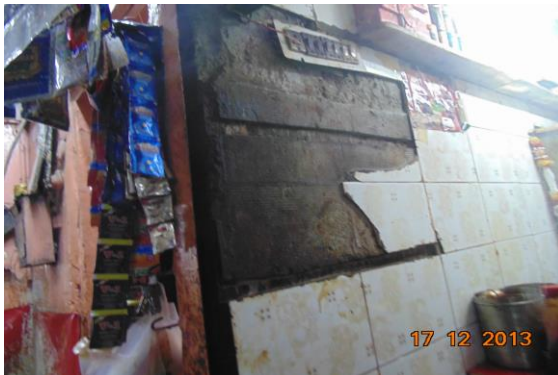
Photo 217
Peeling of Plaster on Wall No. 1 of Murali Pan Bhandar of Ground Floor

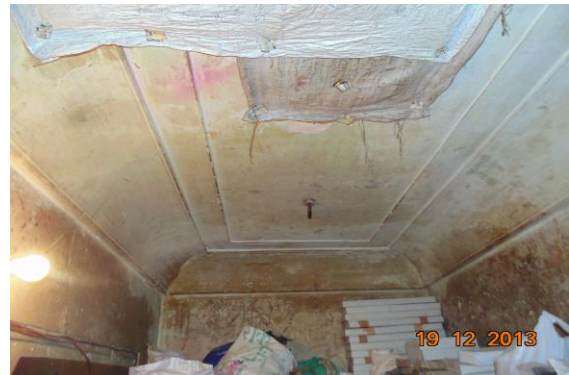
Photo 218
Dampness/Seepage on Wall No. 1, 2 & 4 of Shop Pink city Colour of Upper Ground Floor

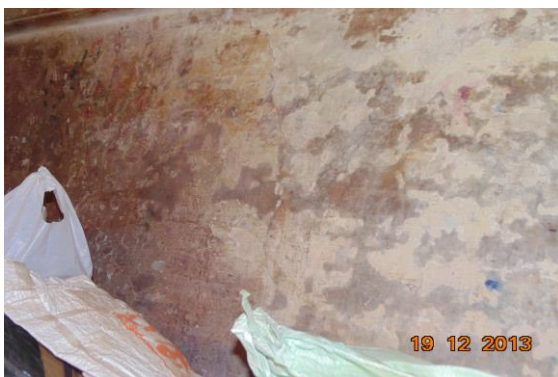
Photo 219
Peeling of Plaster on Wall No. 2 of Shop Pink city Colour of Ground Floor

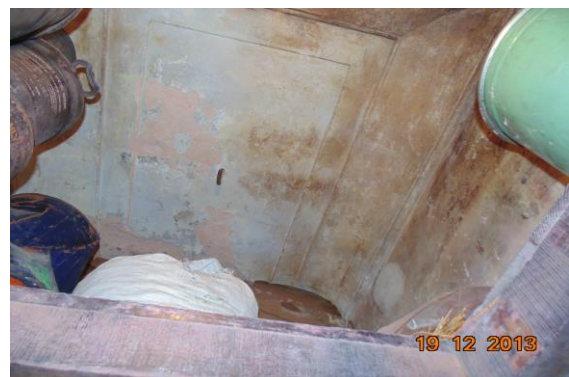
Photo 220
Dampness/Seepage on Wall No.4 & Roof of Part A of Shop Aggarwal Colour of Ground Floor

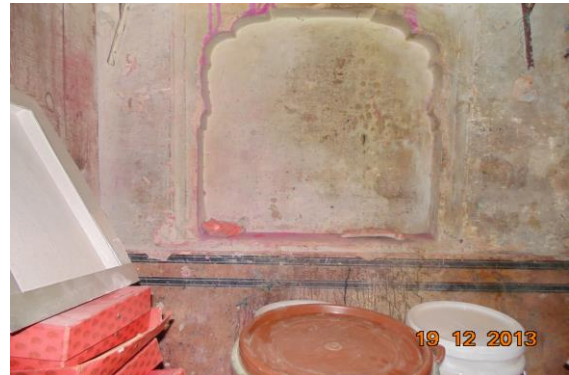
Photo 222

Peeling of Plaster on Wall No. 4 of Part A of Shop Aggarwal Colour of Ground Floor

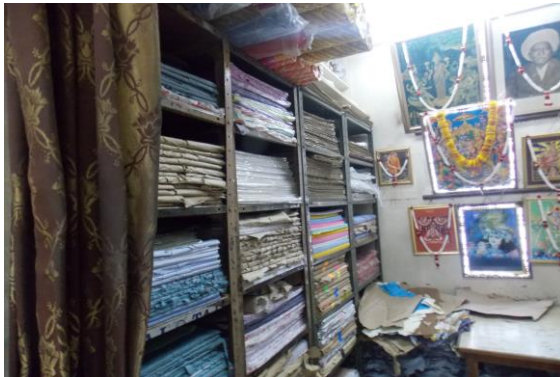
Photo 269

Wall No. 1 & 4 of Part B of Shop No.253 of Ground Floor Covered With Material & Wooden Work

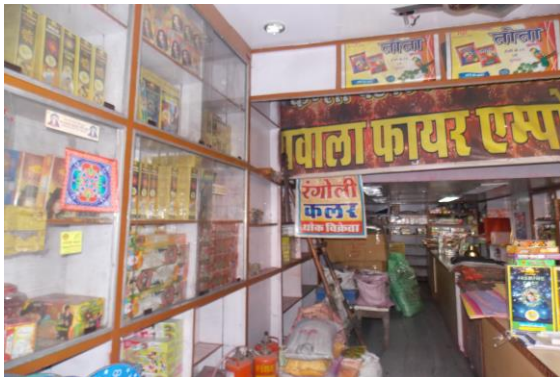
Photo 271

Wall No. 1 & 4 of Shop No.252 of Ground Floor Covered With Material

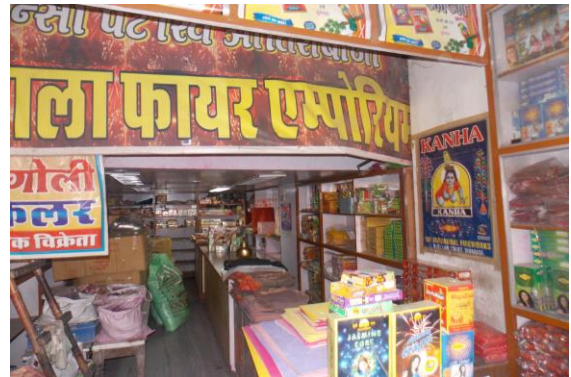
Photo 272

Wall No. 2 & 4 of Shop No.252 of Ground Floor Covered With Material

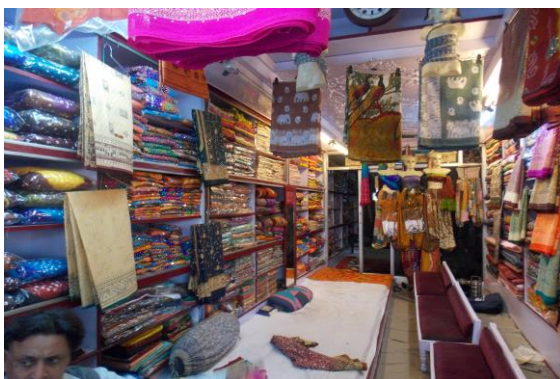
Photo 273

Wall No. 1 & 4 of Shop No.250 of Ground Floor Covered with Material

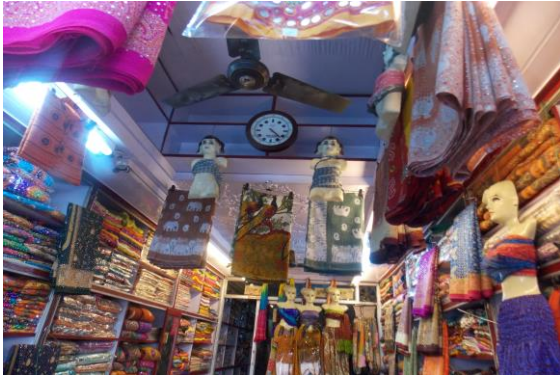
Photo 275

Roof of Shop No.250 of Ground Floor Covered with Wooden Ceiling

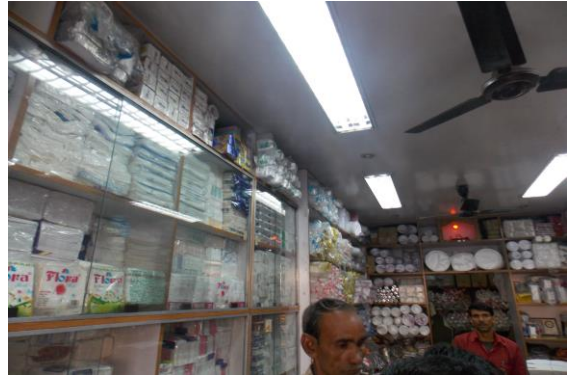
Photo 276

Wall No. 1 & 4 of Shop No.251 of Ground Floor Covered with Material

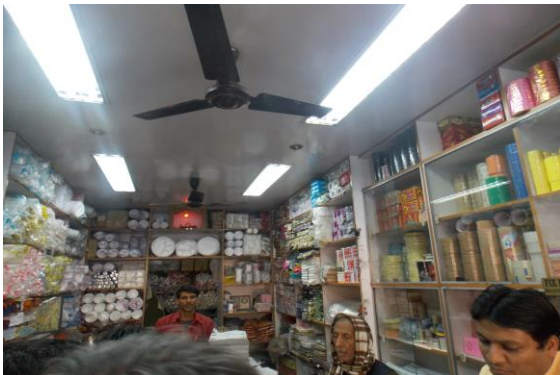
Photo 277

Wall No. 2 & 4 of Shop No.251 of Ground Floor Covered with Material

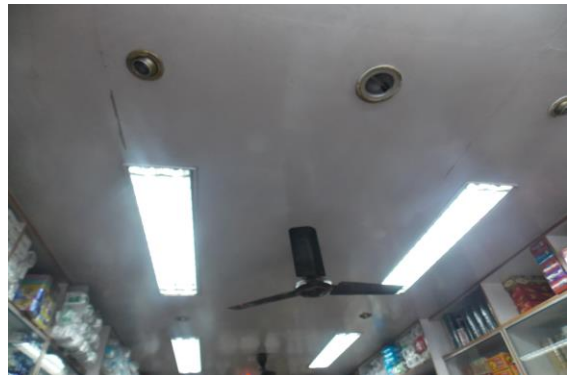
Photo 278

Roof of Shop No.251 of Ground Floor

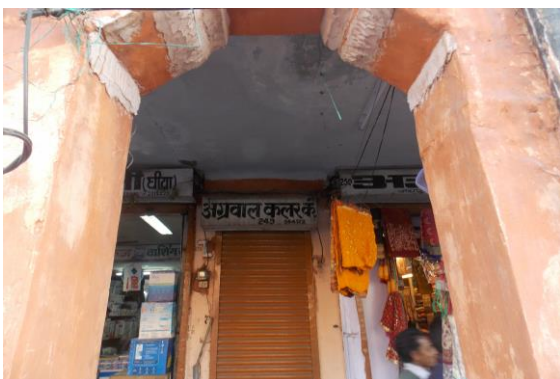
Photo 279

Shop No.249 of Ground Floor Locked

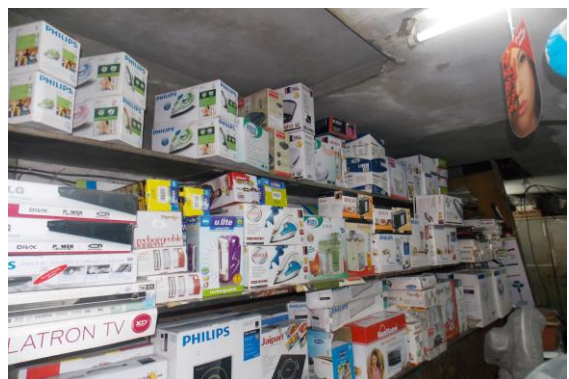
Photo 280

Wall No. 1 of Shop No.248 of Ground Floor Covered With Material

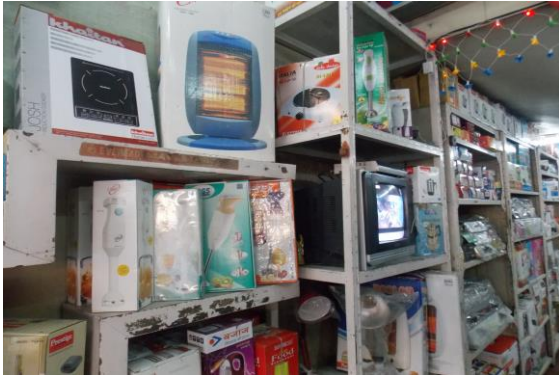
Photo 281

Wall No. 1 of Shop No.247 of Ground Floor Covered With Material

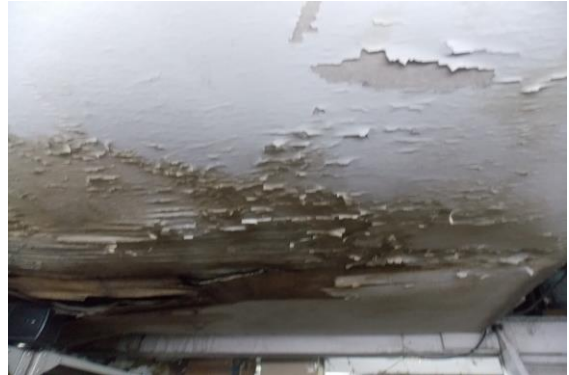
Photo 282

Roof of Shop No.247 of Ground Floor Covered With wooden Ceiling

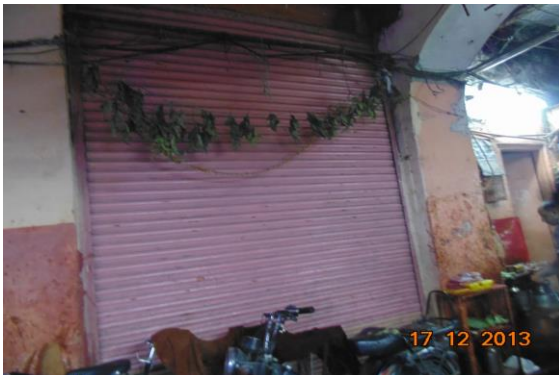
Photo 283

Shop of Ground Floor Locked

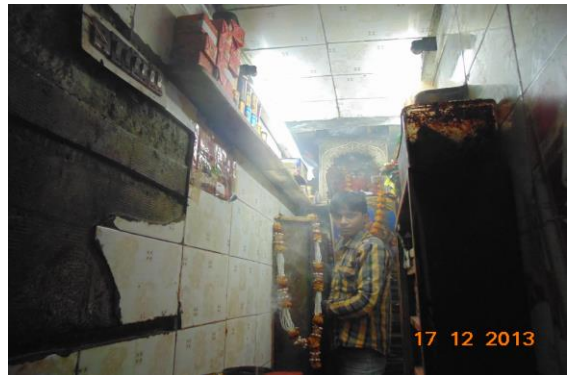
Photo 284

Wall No. 4 & 2 of Murali Pan Bhandar of Ground Floor Covered With Material

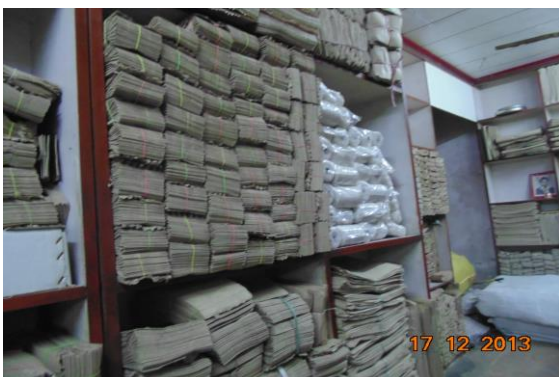
Photo 285

Wall No. 1 of Shop Madan Lal & Company of Ground Floor Covered With Material & Wooden Work

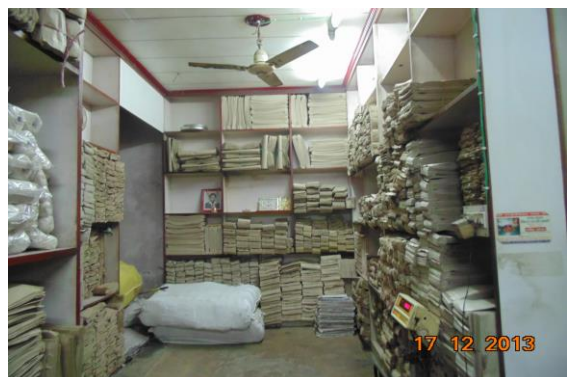
Photo 286

Wall No. 4 of Shop Madan Lal & Company of Ground Floor Covered With Material & Wooden Work

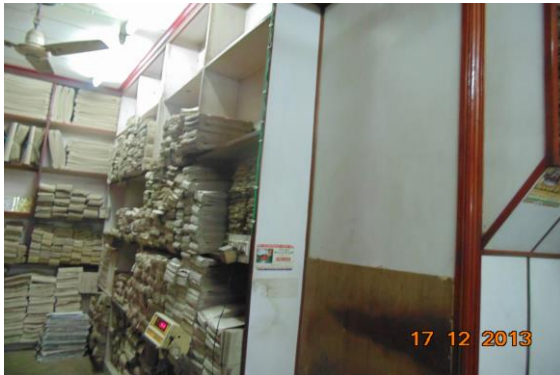
Photo 287

Wall No. 2 of Shop Madan Lal & Company of Ground Floor Covered With Material & Wooden Work

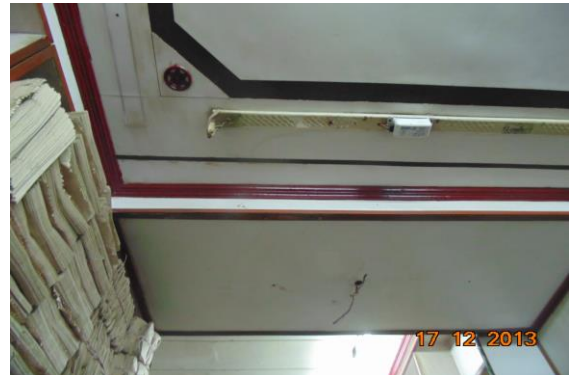
Photo 288

Roof of Shop Madan Lal & Company of Ground Floor Covered With Wooden Work

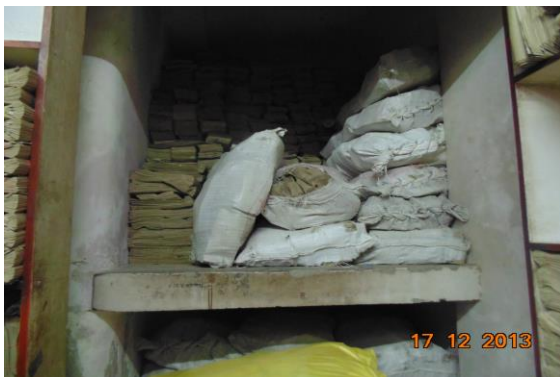
Photo 289

Wall No. 5 of Shop Madan Lal & Company of Ground Floor Covered With Material

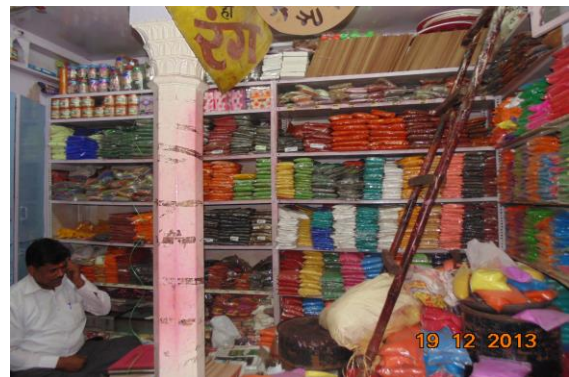
Photo 290

All walls of Shop Pink city Colour of Ground Floor Covered With Wooden Racks & Material

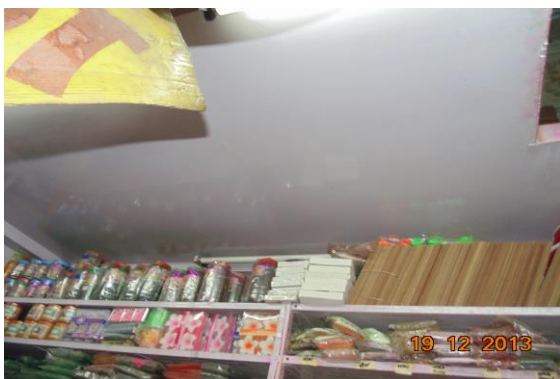
Photo 291

Roof of Shop Pink city Colour of Ground Floor Covered With Wooden Ceiling

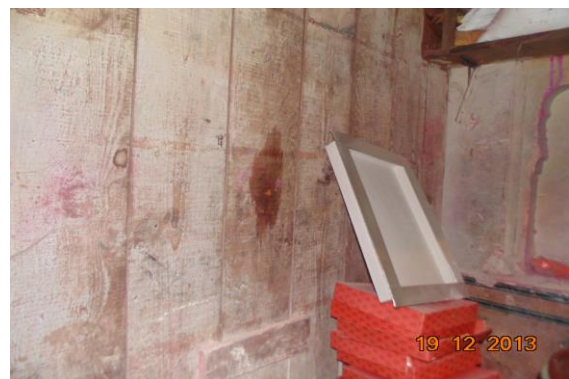
Photo 292

Wall No. 1 of Part A of Shop Aggarwal Colour of Ground Floor Covered With Wooden Partition

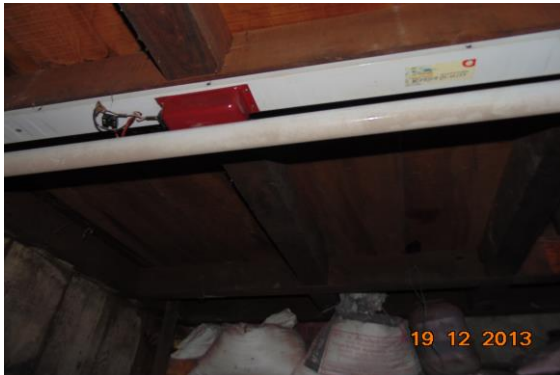
Photo 293

Roof of Part A of Shop Aggarwal Colour of Upper Ground Floor Covered With Falls Ceiling

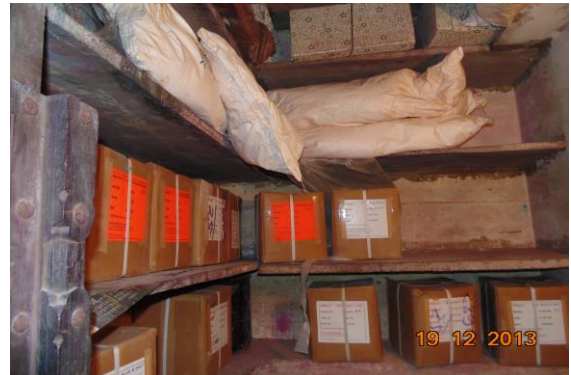
Photo 294

Wall No. 2 & 4 of Part B of Shop Aggarwal Colour of Ground Floor Covered With Material

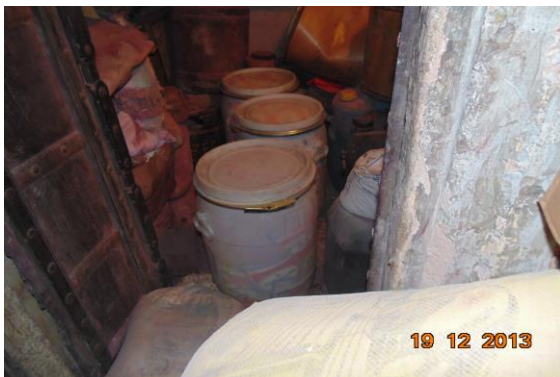
Photo 295

Floor of Part B of Shop Aggarwal Colour of Ground Floor Covered With Material

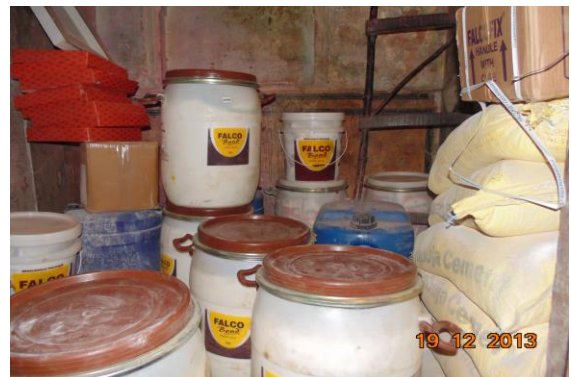
Photo 296

Floor of Part A of Shop Aggarwal Colour of Ground Floor Covered With Material

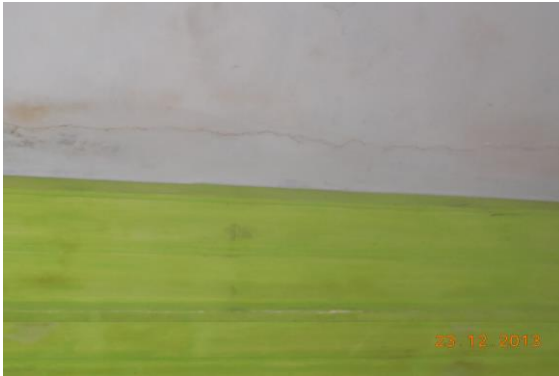
Photo 7

Horizontal Crack on Roof of Hall No. 1, House No.643, Ground Floor
Approx. Width = 0.6mm, Approx. Length = 2.2m. Distance from Wall No.3 = 0m, Height from Floor = 3.5m.

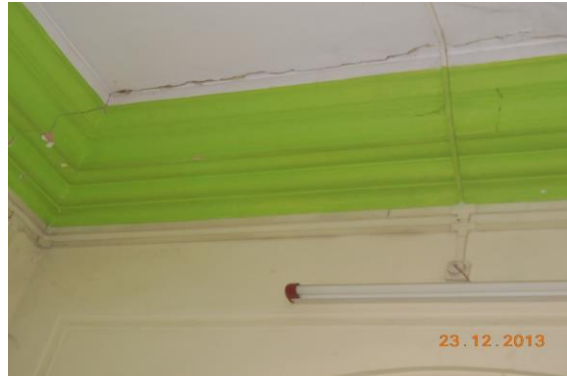
Photo 8

Horizontal Crack on Roof of Hall No. 2, House No.643, Ground Floor
Approx. Width = 2.5mm, Approx. Length = 3.5m. Distance from Wall No.3 = 0m, Height from Floor = 3.5m.

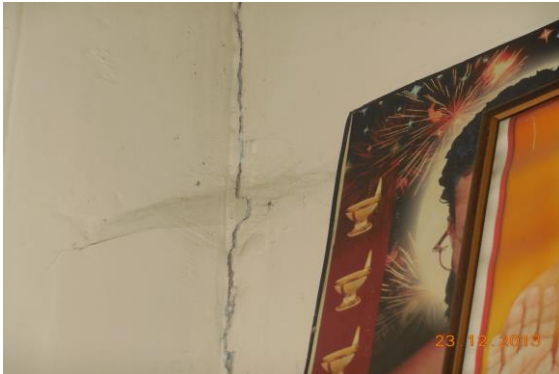
Photo 9

Vertical Crack on Wall No. 2 & 3 of Hall No. 2, House No.643, Ground Floor
Approx. Width = 2.5mm, Approx. Length = 1.5m. Distance from = m, Height from Floor = 2.2m.

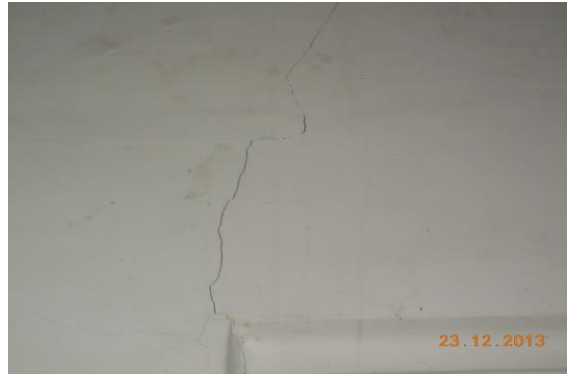
Photo 10

Inclined Crack on Wall No. 4 of Hall No. 2, House No.643, Ground Floor
Approx. Width = 1mm, Approx. Length = 1m. Distance from Wall No.2 = 1.5m, Height from Floor = 2.1m.

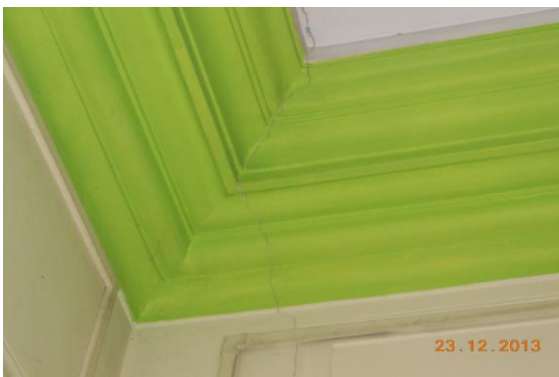
Photo 11

Inclined Crack on Wall No. 6 of Hall No. 2, House No.643, Ground Floor
Approx. Width = 0.8mm, Approx. Length = 4m. Distance from Wall No.1 = 0.3m, Height from Floor = 2.5m.

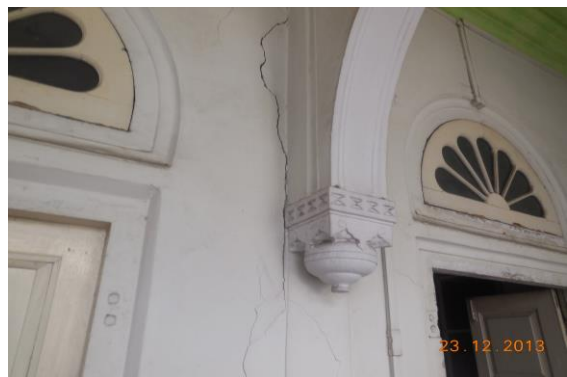
Photo 12

Inclined Crack on Wall No. 4 of Varanda No.3, House No.643, Ground Floor
Approx. Width = 5mm, Approx. Length = 3m. Distance from Wall No.2 = 2.8m, Height from Floor = 1m.

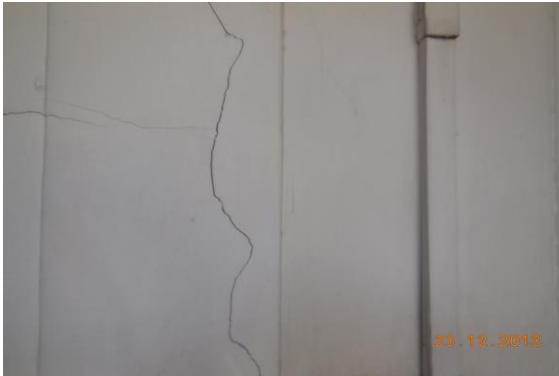
Photo 13

Inclined Crack on Wall No. 4 of Varanda No.3, House No.643, Ground Floor Approx. Width = 0.8mm, Approx. Length = 1m. Distance from Wall No.2 = 2.5m, Height from Floor = 0.9m.

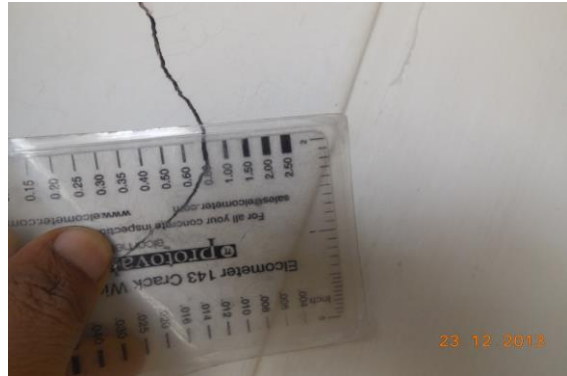
Photo 13A

Inclined Crack on Wall No. 4 of Varanda No.3, House No.643, Ground Floor Approx. Width = 0.8mm, Approx. Length = 1m. Distance from Wall No.2 = 2.5m, Height from Floor = 0.9m.

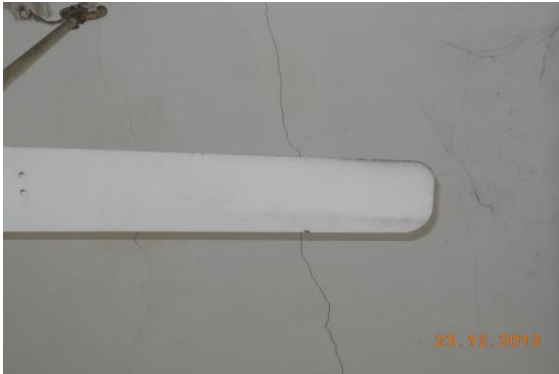
Photo 14

Horizontal Crack on Roof of Varanda No.3, House No.643, Ground Floor Approx. Width = 2mm, Approx. Length = 2.5m. Distance from Wall No.2 = 2m, Height from Floor = 3m.

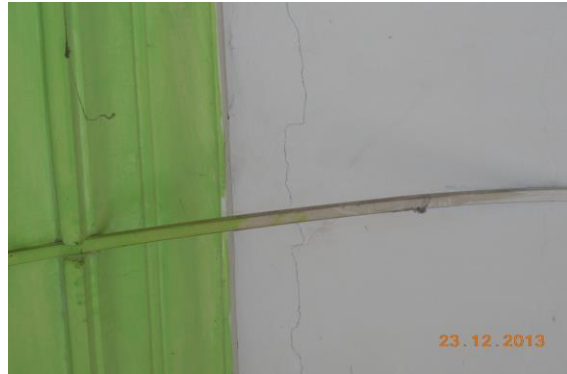
Photo 15

Horizontal Crack on Roof of Varanda No.3, House No.643, Ground Floor Approx. Width = 0.4mm, Approx. Length = 2.5m. Distance from Wall No.2 = 0.4m, Height from Floor = 3m.

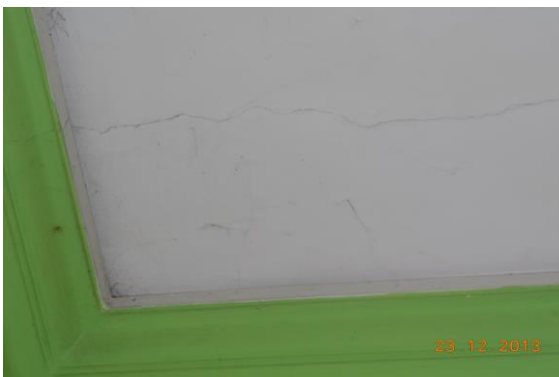
Photo 16

Horizontal Crack on Roof & 3 of Varanda No.3, House No.643, Ground Floor Approx. Width = 1mm, Approx. Length = 2m. Distance from Wall No.1 = 3.5m, Height from Floor = 3m.

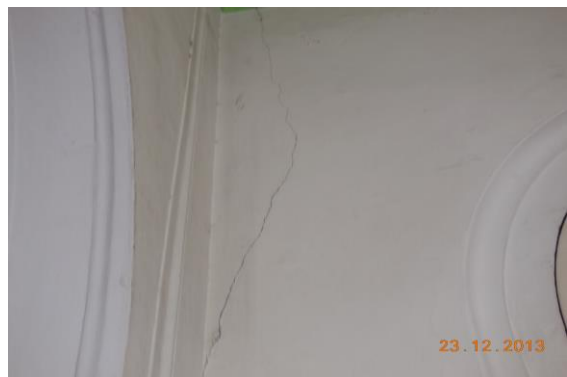
Photo 17

Inclined Crack on Wall No. 4 of Varanda No.3, House No.643, Ground Floor Approx. Width = 1mm, Approx. Length = 1.5m. Distance from Wall No.1 = 2m, Height from Floor = 2.2m.

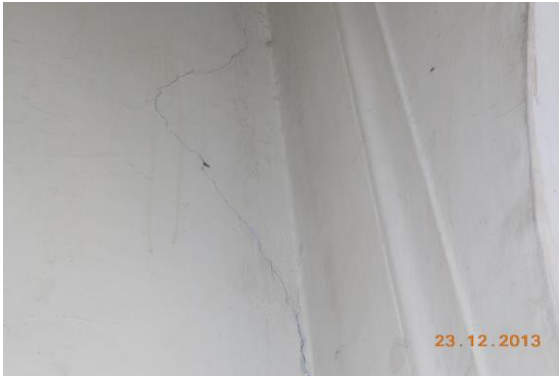
Photo 18

Inclined Crack on Wall No. 4 of Varanda No.3, House No.643, Ground Floor Approx. Width = 1mm, Approx. Length = 0.6m. Distance from Wall No.1 = 2m, Height from Floor = 2.2m.

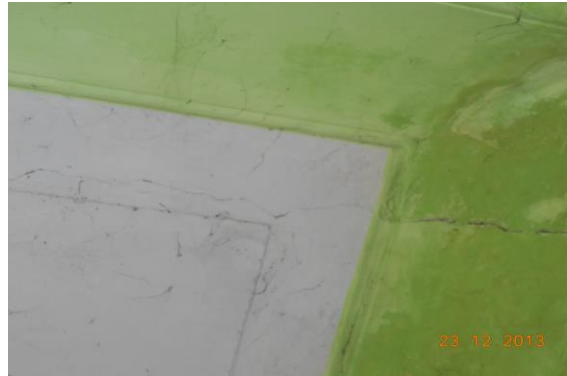
Photo 19

Horizontal Crack on Roof of Varanda No.2, House No.643, Ground Floor Approx. Width = 1.5mm, Approx. Length = 2m. Distance from Wall No.2 = 1m, Height from Floor = 2.6m.

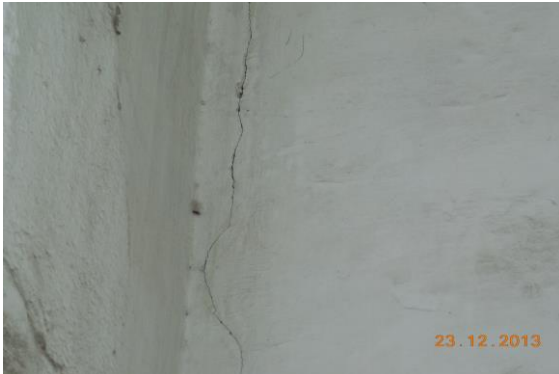
Photo 20

Inclined Crack on Wall No. 4 of Varanda No.4, House No.643, Ground Floor Approx. Width = 2mm, Approx. Length = 2m. Distance from Wall No.2 = 1.5m, Height from Floor = 2m.

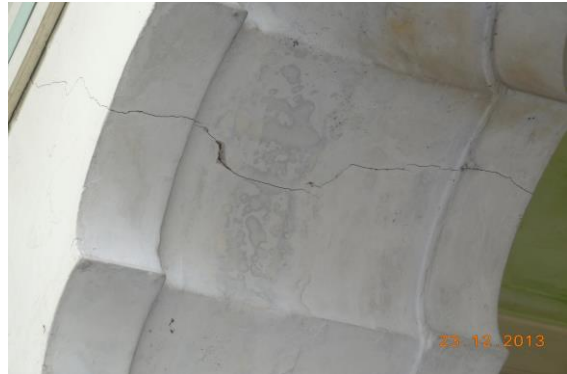
Photo 21

Inclined Crack on Wall No. 4 of Varanda No.4, House No.643, Ground Floor Approx. Width = 1mm, Approx. Length = 2m. Distance from Wall No.4 = 1.3m, Height from Floor = 2.5m.

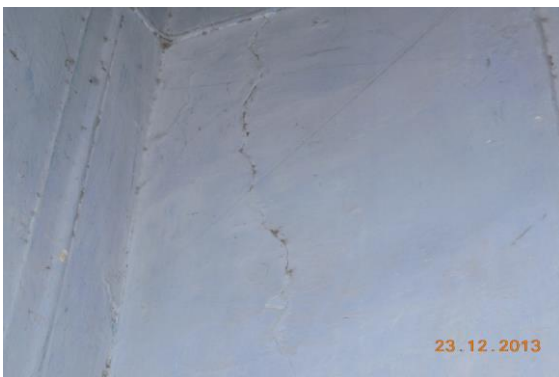
Photo 22

Inclined Crack on Wall No. 1 of Room No. 1 (Part 1), House No.643, Ground Floor Approx. Width = 2mm, Approx. Length = 2m. Distance from Wall No.3 = 0.1m, Height from Floor = 1.7m.

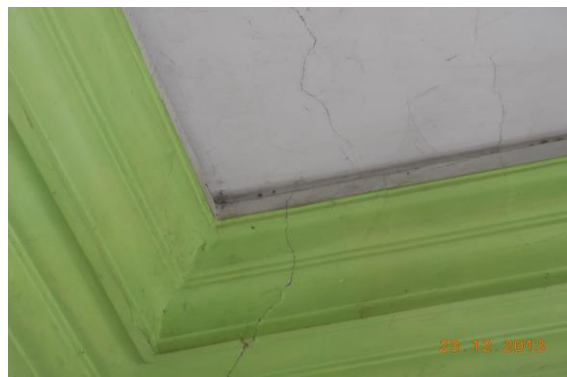
Photo 23

Inclined Crack on Wall No. 4 & Roof of Varanda No.1, House No.643, Ground Floor Approx. Width = 1mm, Approx. Length = 3m. Distance from Wall No.1 = 0.3m, Height from Floor = 3m.

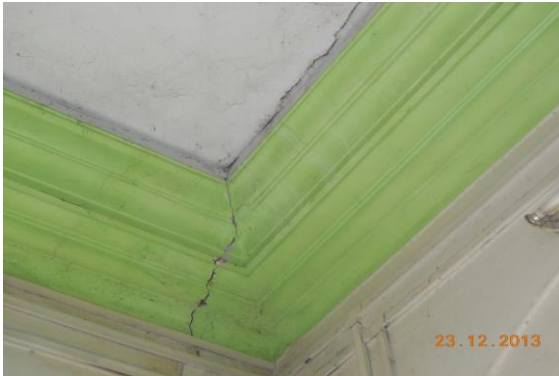
Photo 24

Inclined Crack on Wall No. 4 & Roof of Varanda No.1, House No.643, Ground Floor Approx. Width = 2mm, Approx. Length = 5m. Distance from Wall No.2 = 0.3m, Height from Floor = 1m.

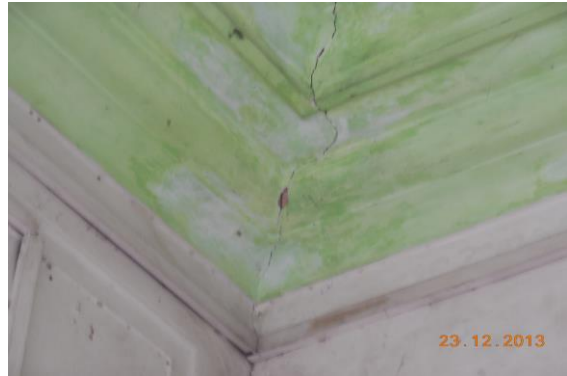
Photo 24A

Inclined Crack on Wall No. 4 & Roof of Varanda No.1, House No.643, Ground Floor Approx. Width = 2mm, Approx. Length = 5m. Distance from Wall No.2 = 0.3m, Height from Floor = 1m.

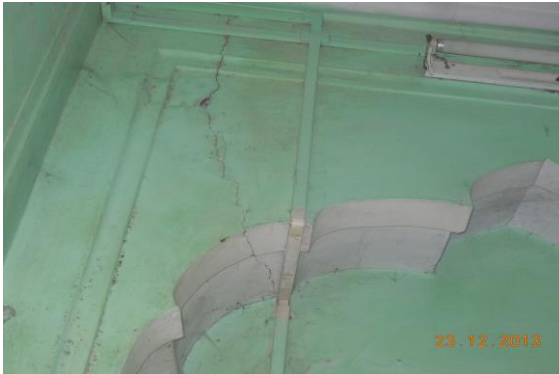
Photo 25

Inclined Crack on Wall No. 1 of Room No. 2 (Part 1), House No.643, Ground Floor Approx. Width = 1.5mm, Approx. Length = 1m. Distance from Wall No.3 = 0.2m, Height from Floor = 2.5m.

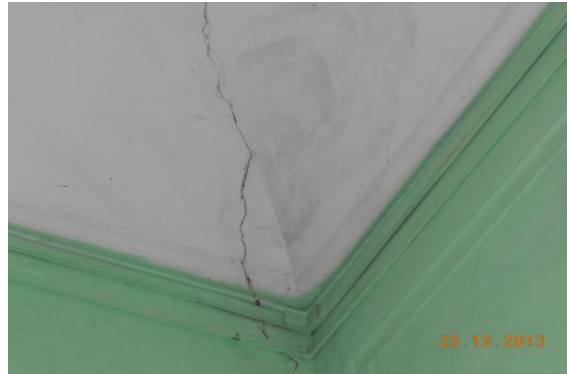
Photo 26

Horizontal Crack on Roof of Room No. 2 (Part 1), House No.643, Ground Floor Approx. Width = 2mm, Approx. Length = 1.5m. Distance from Wall No.3 = 0m, Height from Floor = 3m.

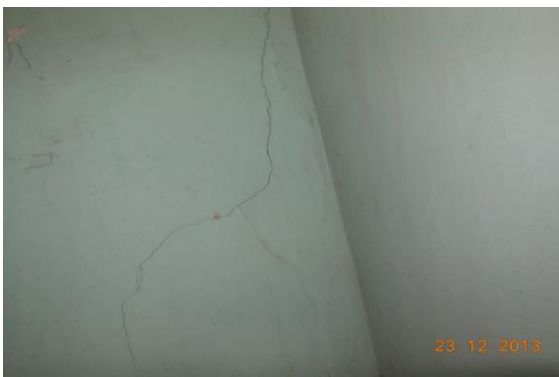
Photo 27

Inclined Crack on Wall No. 2 & 3 of Room No. 2 (Part 1), House No.643, Ground Floor Approx. Width = 1mm, Approx. Length = 2m. Distance from = Corner Wall No.2 & 3m, Height from Floor = 1m.

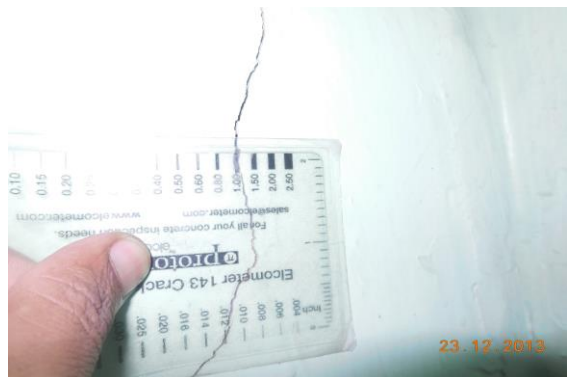
Photo 27A

Inclined Crack on Wall No. 2 & 3 of Room No. 2 (Part 1), House No.643, Ground Floor Approx. Width = 1mm, Approx. Length = 2m. Distance from = Corner Wall No.2 & 3m, Height from Floor = 1m.

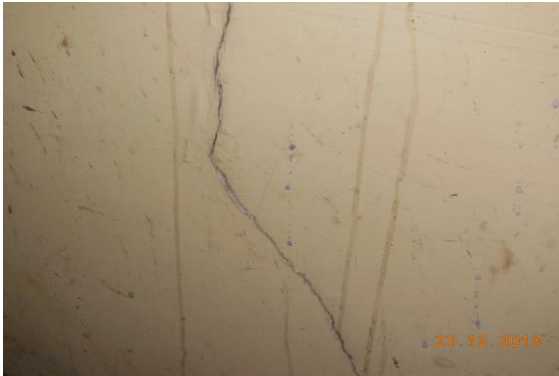
Photo 28

Inclined Crack on Wall No. 2 of Room No. 2 (Part 1), House No.643, Ground Floor Approx. Width = 1.5mm, Approx. Length = 1.3m. Distance from Wall No.3 = 0.8m, Height from Floor = 0m.

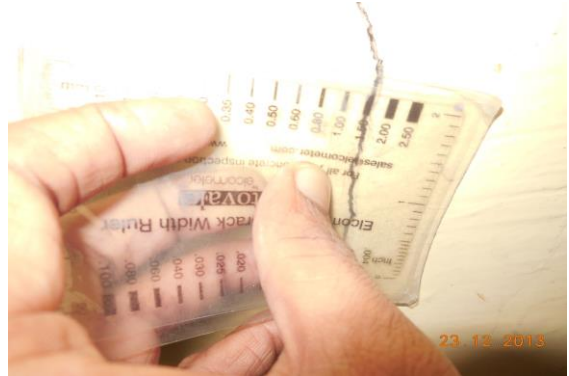
Photo 28A

Inclined Crack on Wall No. 2 of Room No. 2 (Part 1), House No.643, Ground Floor Approx. Width = 1.5mm, Approx. Length = 1.3m. Distance from Wall No.3 = 0.8m, Height from Floor = 0m.

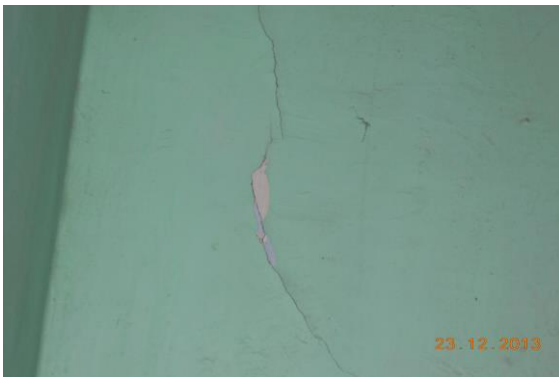
Photo 29

Inclined Crack on Wall No. 2 of Room No. 2 (Part 1), House No.643, Ground Floor Approx. Width = 0.2mm, Approx. Length = 0.9m. Distance from Wall No.3 = 2m, Height from Floor = 1.7m.

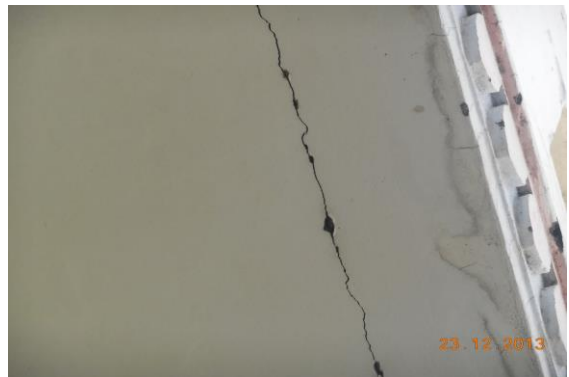
Photo 30

Horizontal Crack on Wall No. 4 & Shade of Open Sky, Ground Floor Approx. Width = 5mm, Approx. Length = 3m. Distance from = m, Height from Floor = m.

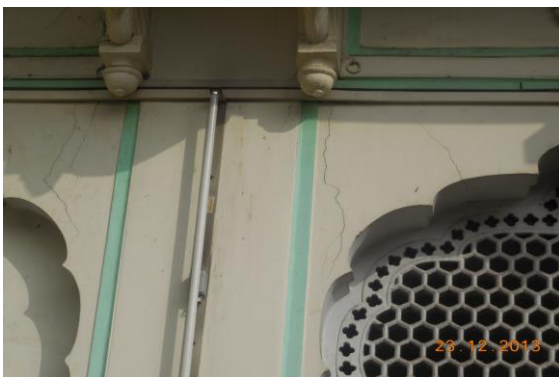
Photo 31

Inclined Crack on Wall No. 3 of Open Sky, Ground Floor Approx. Width = 7mm, Approx. Length = 2m. Distance from = m, Height from Floor = m.

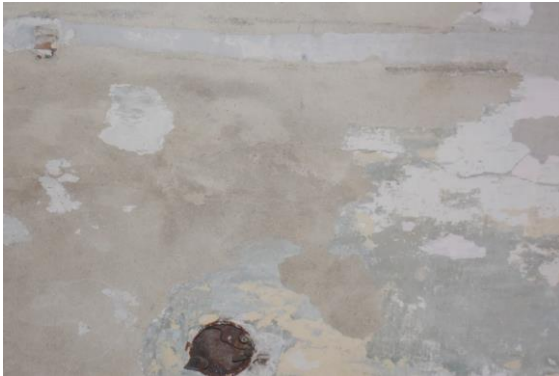
Photo 33

Inclined Crack on Roof of Varanda of Shop No.246, Ground Floor
Approx. Width = 0.1mm, Approx. Length = 2.5m. Distance from Leftside External Column = 1m, Height from Floor = 3m.

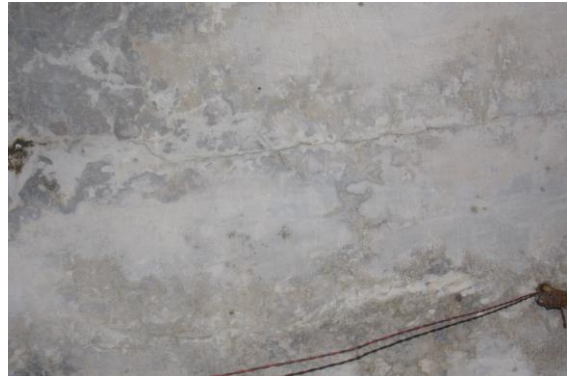
Photo 34

Horizontal Crack on Roof of Varanda of Shop No.245, Ground Floor
Approx. Width = 0.1mm, Approx. Length = 2.5m. Distance from Rightside External Column = 1.2m, Height from Floor = 3m.

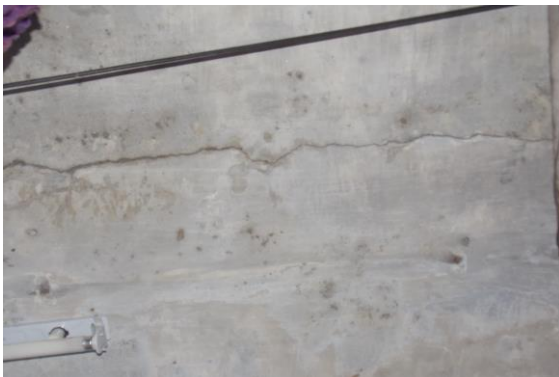
Photo 35

Horizontal Crack on Roof of Varanda of Shop No.245, Ground Floor
Approx. Width = 2mm, Approx. Length = 2.5m. Distance from Leftside External Column = Backsidem, Height from Floor = 3m.

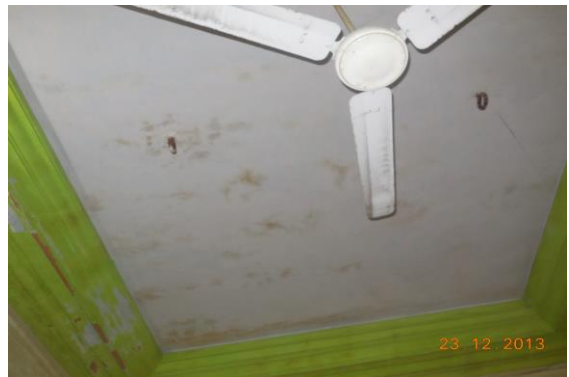
Photo 36

Dampness/Seepage on Roof of Hall No. 1 of House No.643, Ground Floor

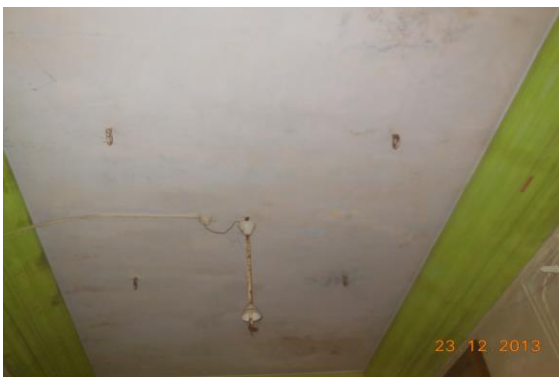
Photo 37

Dampness/Seepage on Roof of Hall No. 1 of House No.643, Ground Floor

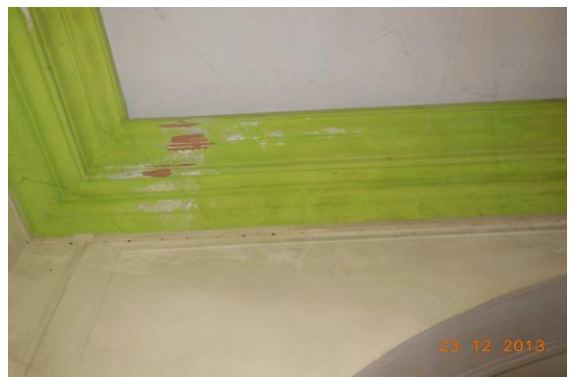
Photo 38

Dampness/Seepage on Roof of Hall No. 1 of House No.643, Ground Floor

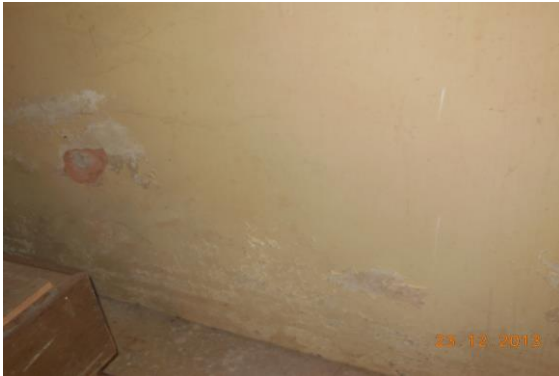
Photo 39

Peeling of Plaster on Wall No. 4 of Hall No. 1 of House No.643, Ground Floor

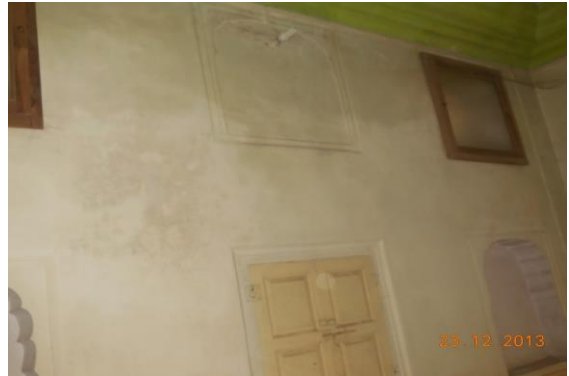
Photo 40

Dampness/Seepage on Wall No. 4 of Hall No. 1 of House No.643, Ground Floor

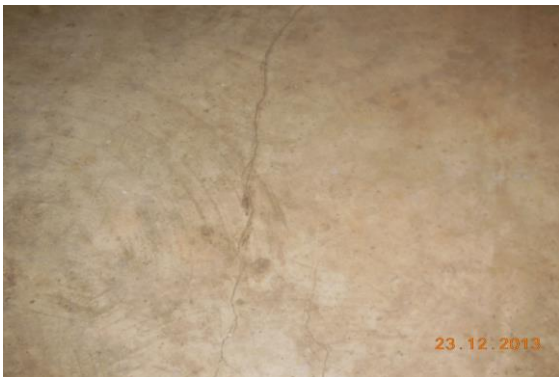
Photo 41

Peeling of Plaster on Floor of Hall No. 1 of House No.643, Ground Floor

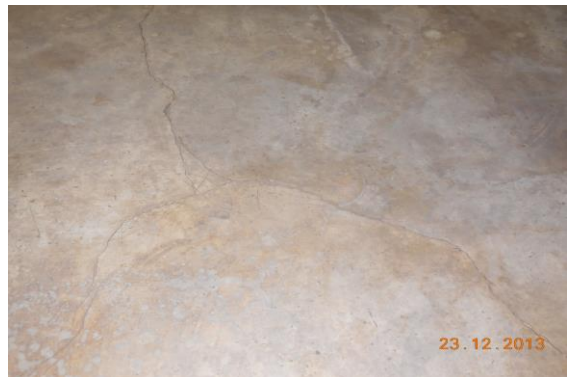
Photo 42

Peeling of Plaster on Floor of Hall No. 2 of House No.643, Ground Floor
