Pre Building Condition Survey Report

Name and Address of Structure :	Choti Chopar to Badi Chopar (Down Line)
---------------------------------	---

Name of the Project	Contract JMRC-UG1B “Design and Construction of Tunnel between Chandpole and Badi Chouper and reverse line by Shield TBM, Underground Metro Stations at Choti Chouper and Badi Chouper by Cut and Cover Methods on East West Corridor of Jaipur Metro Rail Corporation Limited .”	
Owner :

Pre Building Condition Survey Report Choti Chopar to Badi Chopar (Down Line)

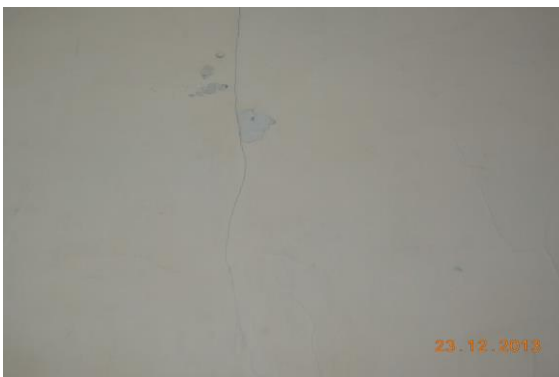
Photo 43

Peeling of Plaster on Wall No. 4 of Hall No. 2 of House No.643, Ground Floor

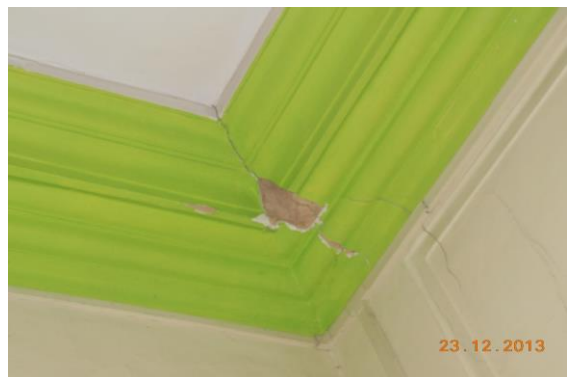
Photo 44

Damaged Portion on Roof of Hall No. 2 of House No.643, Ground Floor

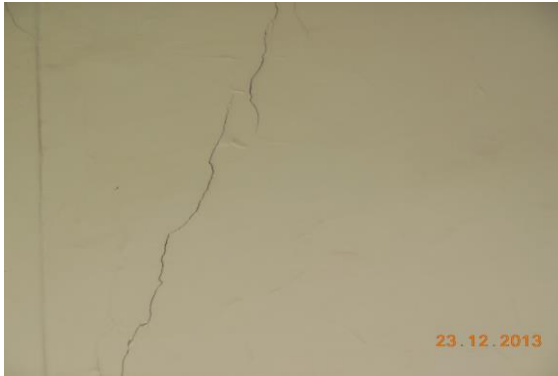
Photo 45

Damaged Portion on Wall No. 5 of Hall No. 2 of House No.643, Ground Floor

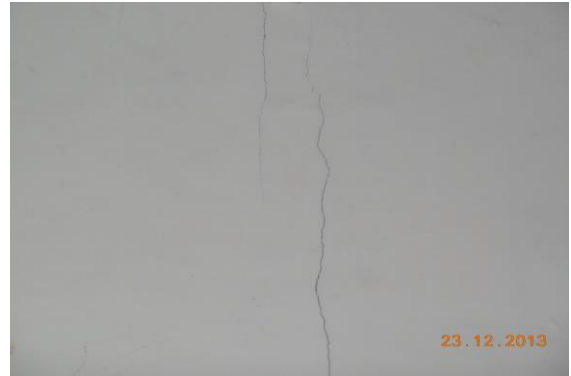
Photo 46

Peeling of Plaster on Wall No. 4 of Hall No. 2 of House No.643, Ground Floor

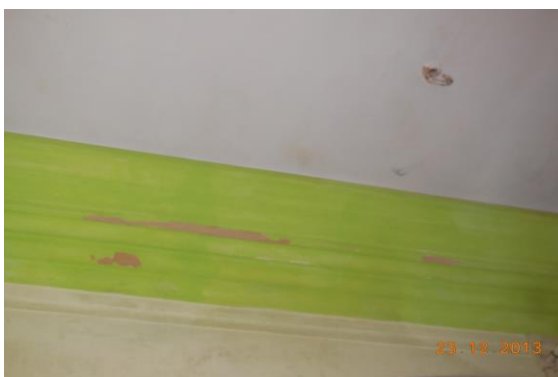
Photo 49

Peeling of Plaster on Roof of Hall No. 3 of House No.643, Ground Floor

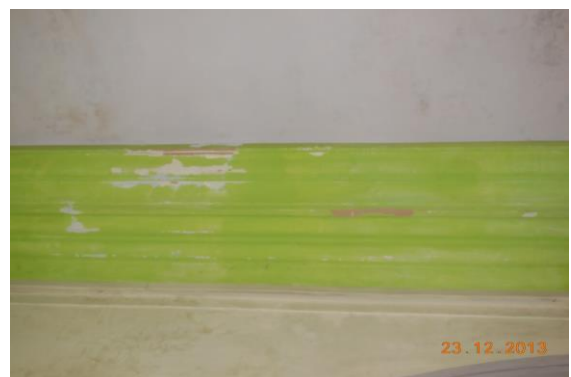
Photo 50

Peeling of Plaster on Roof of Hall No. 3 of House No.643, Ground Floor

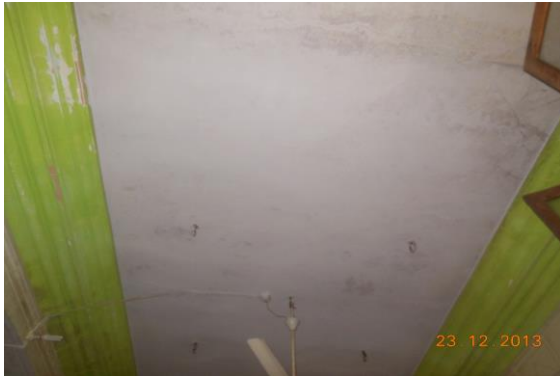
Photo 51

Dampness/Seepage on Roof of Hall No. 3 of House No.643, Ground Floor

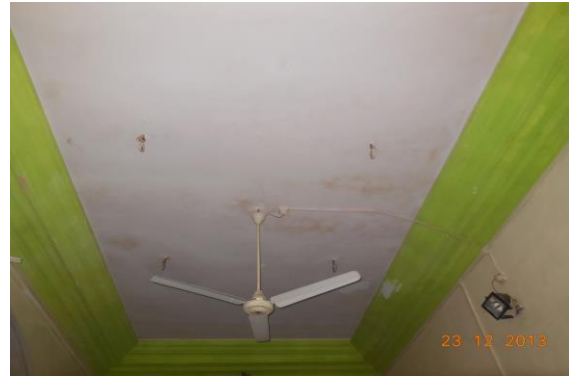
Photo 52

Dampness/Seepage on Roof of Hall No. 3 of House No.643, Ground Floor

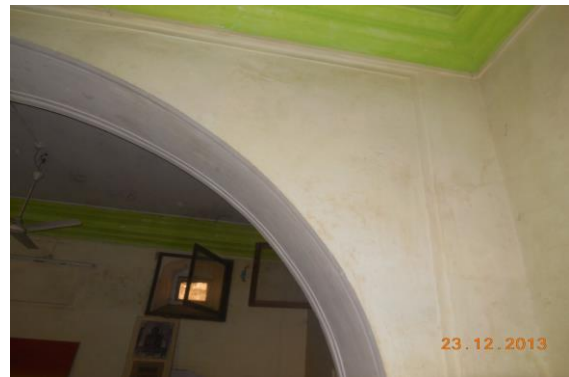
Photo 54

Dampness/Seepage on Wall No. 6 of Hall No. 3 of House No.643, Ground Floor

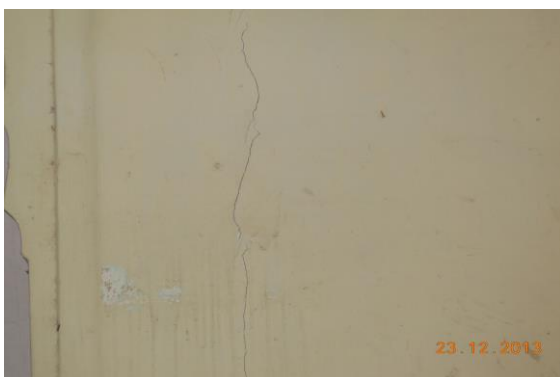
Photo 55

Peeling of Plaster on Wall No. 4 of Hall No. 3 of House No.643, Ground Floor

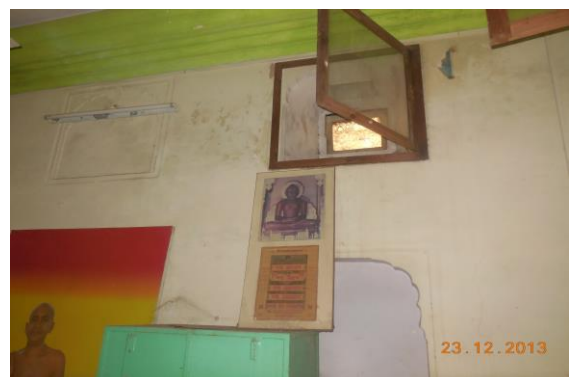
Photo 56

Dampness/Seepage on Wall No. 4 of Hall No. 3 of House No.643, Ground Floor

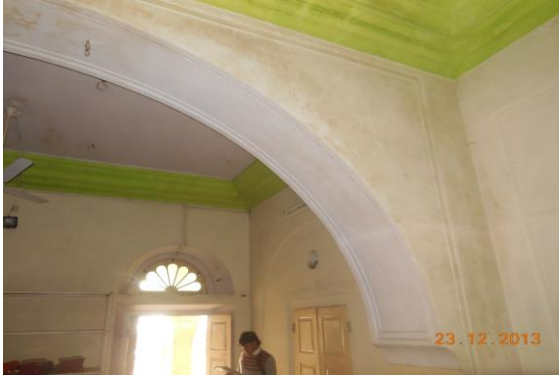
Photo 57

Dampness/Seepage on Wall No. 5 of Hall No. 3 of House No.643, Ground Floor

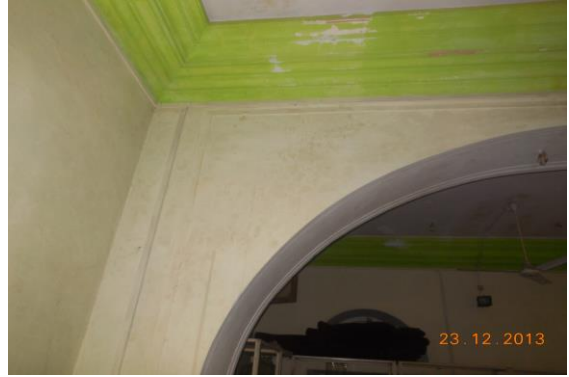
Photo 58

Dampness/Seepage on Wall No. 5 of Hall No. 3 of House No.643, Ground Floor

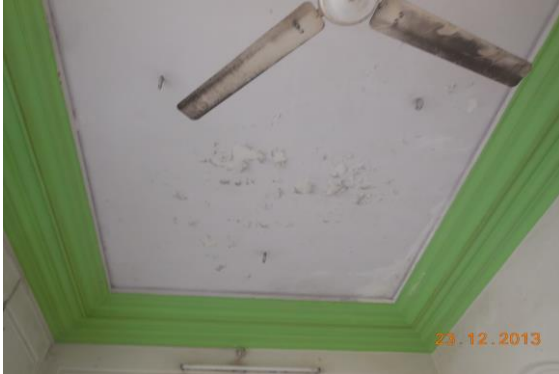
Photo 59

Dampness/Seepage on Roof of Varanda No.3 of House No.643, Ground Floor

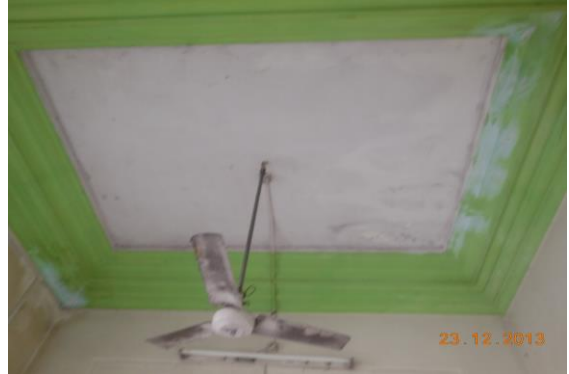
Photo 60

Dampness/Seepage on Roof of Varanda No.3 of House No.643, Ground Floor

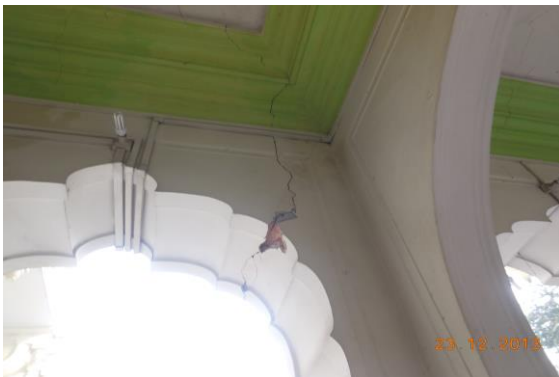
Photo 61

Damaged Portion on Roof of Varanda No.3 of House No.643, Ground Floor

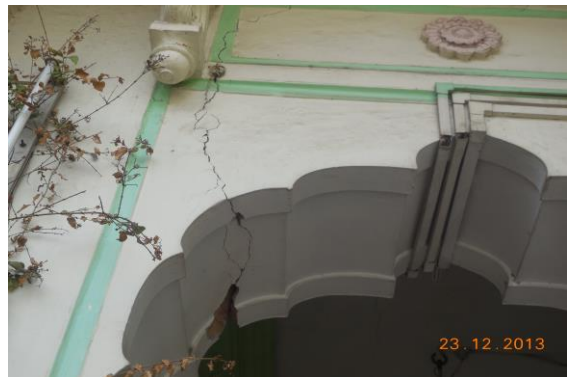
Photo 62

Damaged Portion on Roof of Varanda No.3 of House No.643, Ground Floor

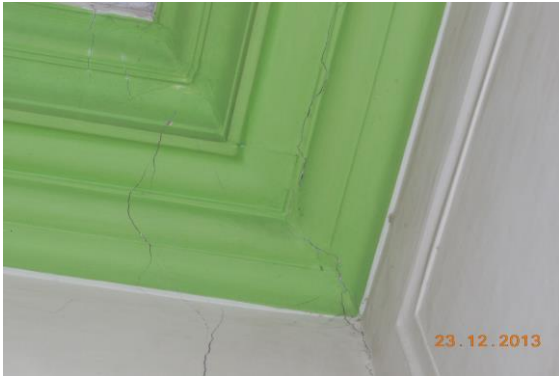
Photo 63

Dampness/Seepage on Roof of Varanda No.3 of House No.643, Ground Floor

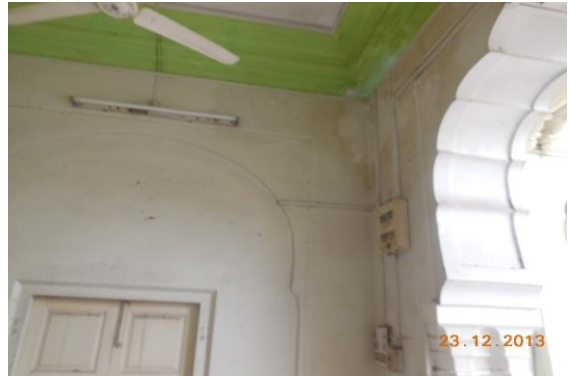
Photo 64

Dampness/Seepage on Wall No. 2 & 3 of Varanda No.3 of House No.643, Ground Floor

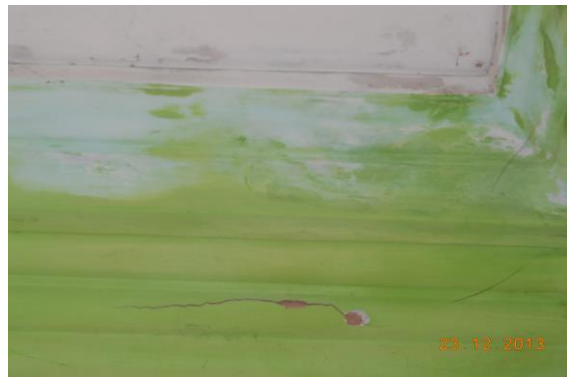
Photo 66

Dampness/Seepage on Roof of Varanda No.3 of House No.643, Ground Floor

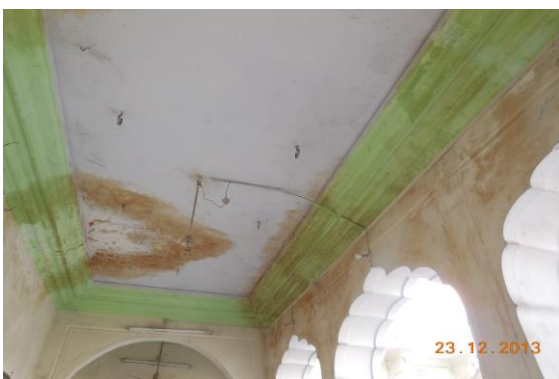
Photo 67

Dampness/Seepage on Wall No 3 & Roof of Varanda No.2 of House No.643, Ground Floor

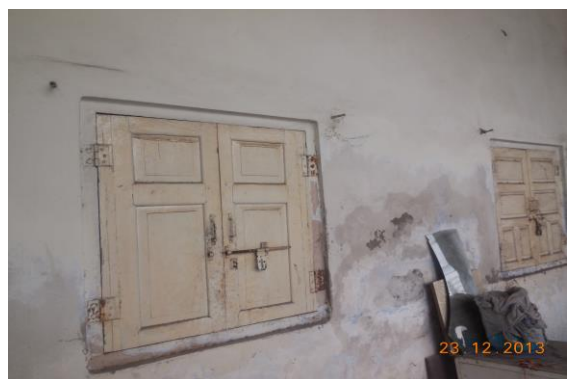
Photo 68

Dampness/Seepage on Wall No. 4 of Varanda No.2 of House No.643, Ground Floor

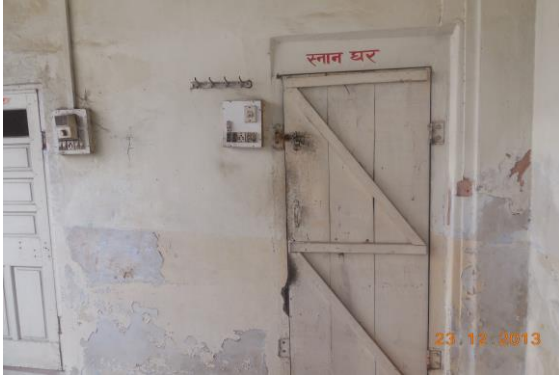
Photo 69

Dampness/Seepage on Wall No. 1 of Varanda No.2 of House No.643, Ground Floor

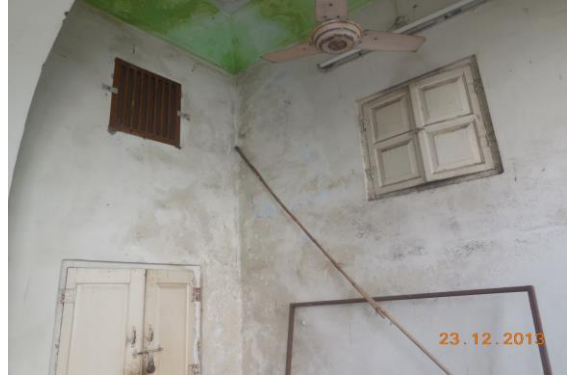
Photo 70

Dampness/Seepage on Wall No. 2, 4 & R of Varanda No.2 of House No.643, Ground Floor

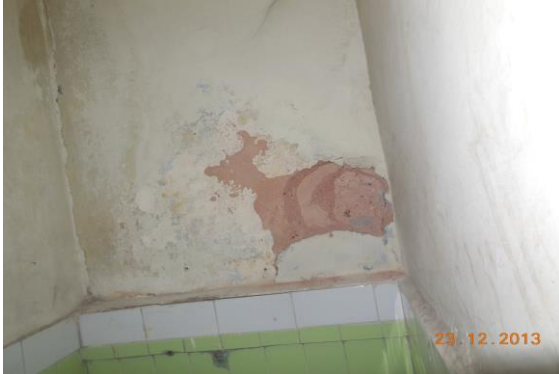
Photo 71

Dampness/Seepage on Wall No. 2 of Toilet No. 1 of House No.643, Ground Floor

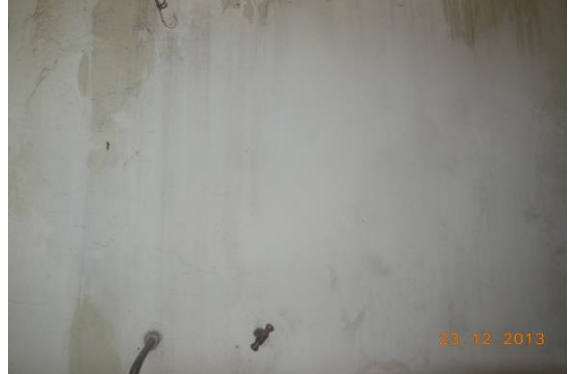
Photo 72

Dampness/Seepage on Wall No. 4 of Toilet No. 1 of House No.643, Ground Floor

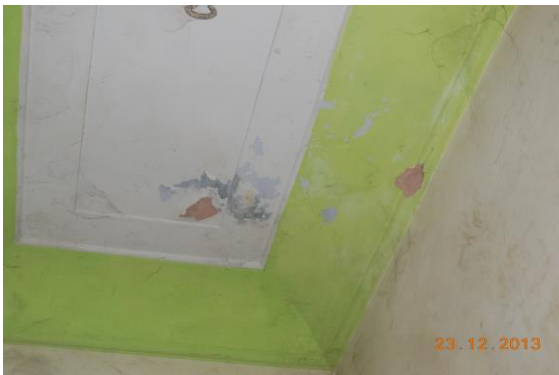
Photo 73

Peeling of Plaster on Roof of Toilet No. 1 of House No.643, Ground Floor

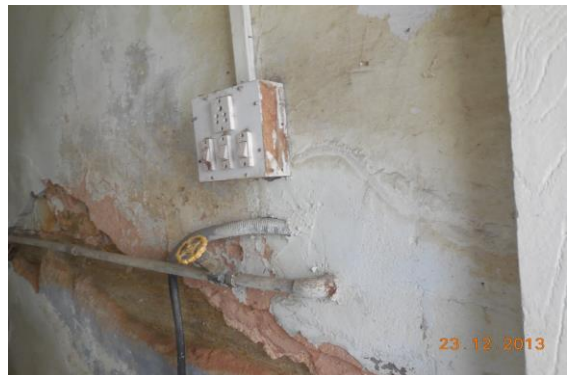
Photo 74

Dampness/Seepage on Wall No. 2 of Gallery No.1 of House No.643, Ground Floor

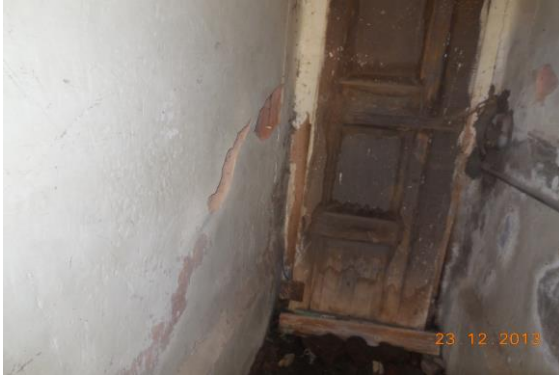
Photo 75

Dampness/Seepage on Wall No. 1 of Gallery No.1 of House No.643, Ground Floor

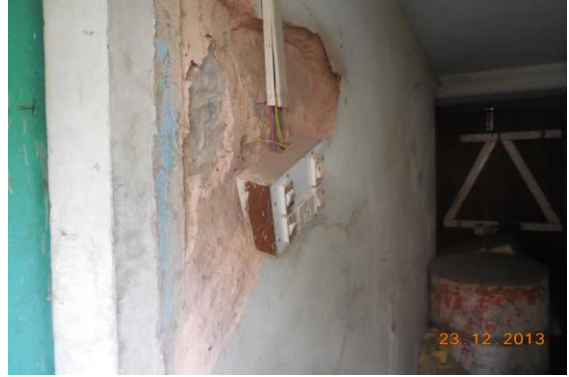
Photo 76

Damaged Portion on Wall No. 1 of Gallery No.3 of House No.643, Ground Floor

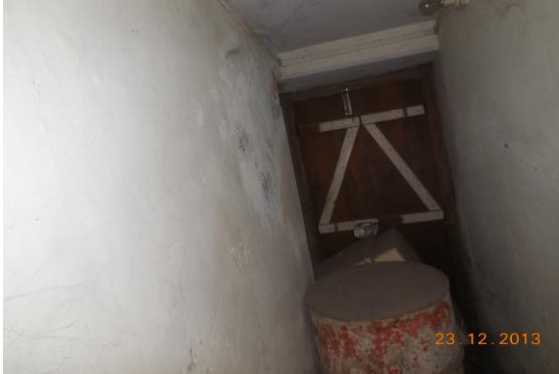
Photo 77

Dampness/Seepage on Wall No. 1 of Gallery No.3 of House No.643, Ground Floor

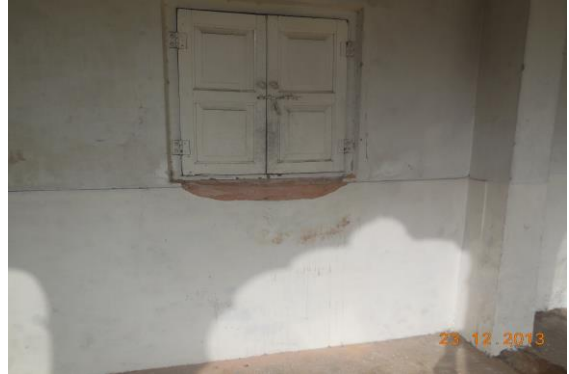
Photo 78

Peeling of Plaster on Wall No. 4 of Varanda No.4 of House No.643, Ground Floor

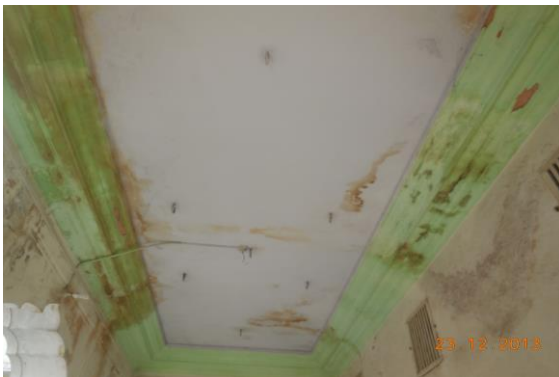
Photo 79

Dampness/Seepage on Roof of Varanda No.4 of House No.643, Ground Floor

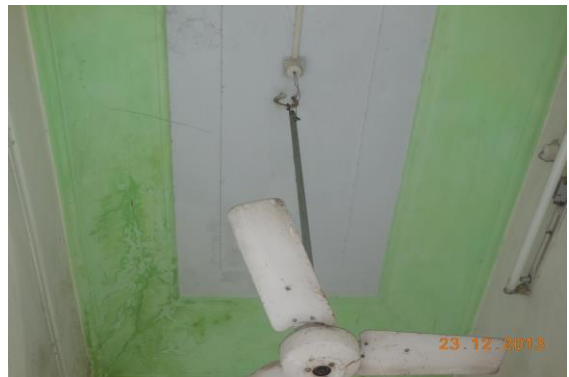
Photo 80

Dampness/Seepage on Roof of Varanda No.4 of House No.643, Ground Floor

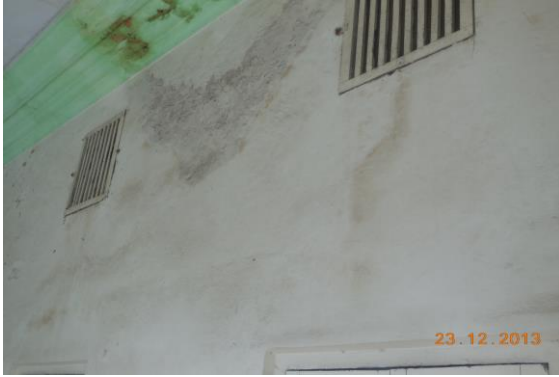
Photo 81

Dampness/Seepage on Wall No. 4 of Varanda No.4 of House No.643, Ground Floor

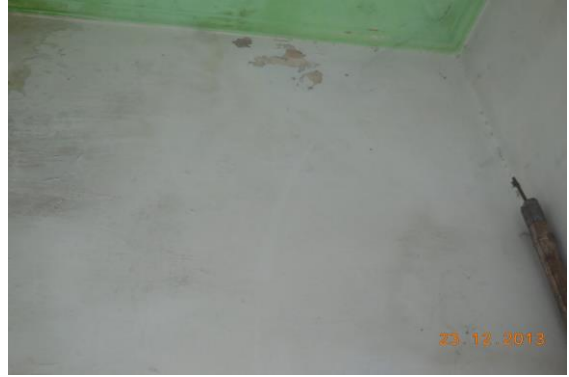
Photo 82

Dampness/Seepage on Wall No. 4 of Varanda No.4 of House No.643, Ground Floor

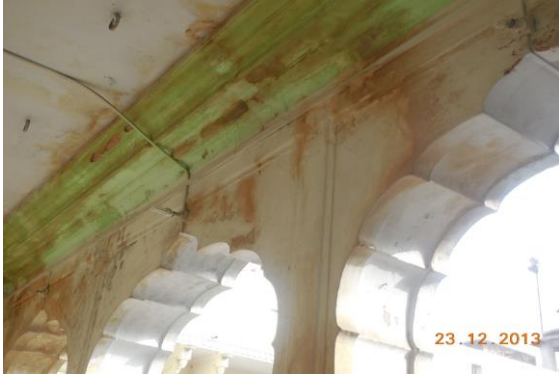
Photo 83

Dampness/Seepage on Wall No. 3 & Roof of Varanda No.4 of House No.643, Ground Floor

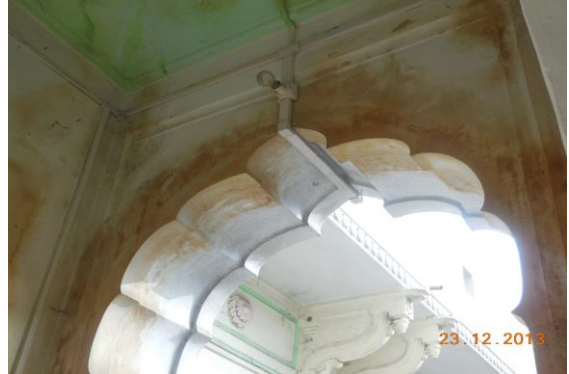
Photo 84

Dampness/Seepage on Wall No. 3 & Roof of Varanda No.4 of House No.643, Ground Floor

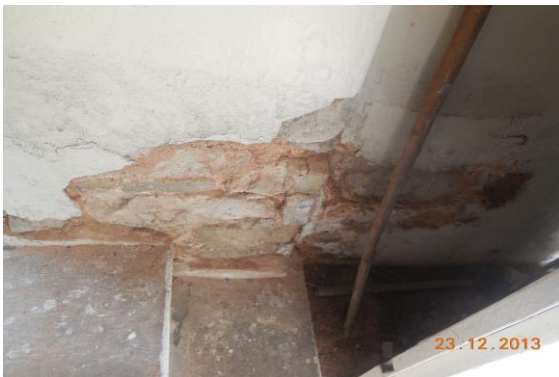
Photo 85

Damaged Portion on Wall No. 2 of Staircase No.2 of House No.643, Ground Floor

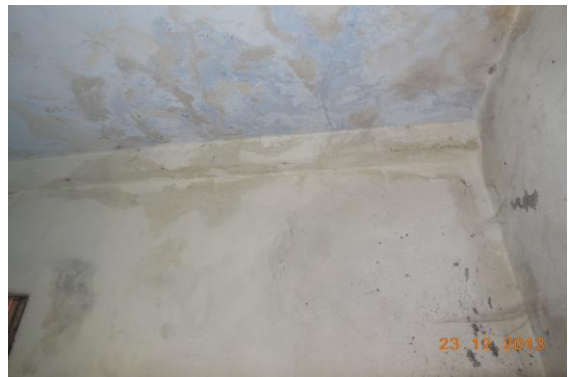
Photo 86

Dampness/Seepage on Wall No. 2 & 4 of Toilet No. 1 of House No.643, Ground Floor

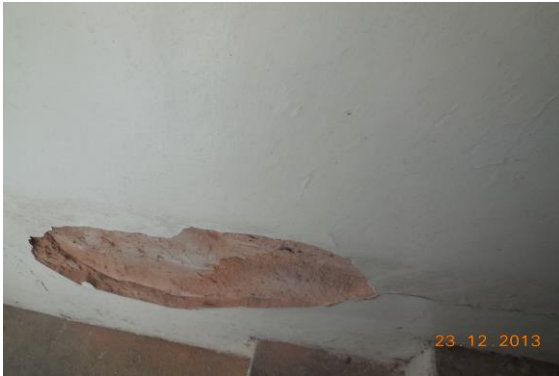
Photo 87

Damaged Portion on Wall No. 1 of Staircase area of Ground Floor

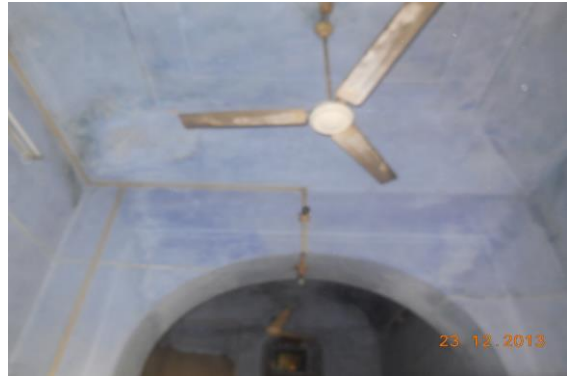
Photo 88

Dampness/Seepage on Wall No.1,2 & Roof, of Room No. 1 (Part 1) of House No.643, Ground Floor

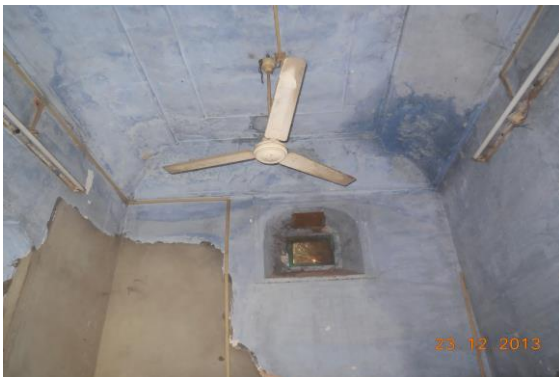
Photo 89

Dampness/Seepage on Wall No. 1,2 & Roof of Room No. 1 (Part 2) of House No.643, Ground Floor

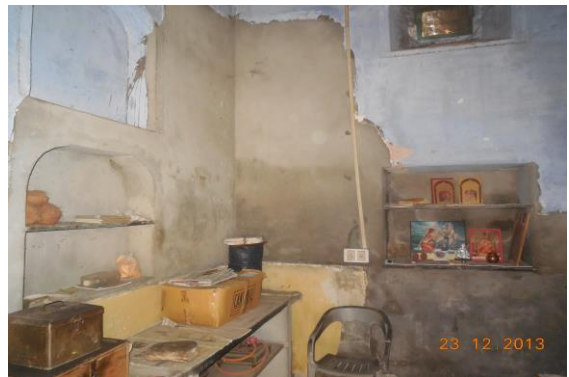
Photo 90

Peeling of Plaster on Wall No. 1 & 4 of Room No. 1 (Part 2) of House No.643, Ground Floor

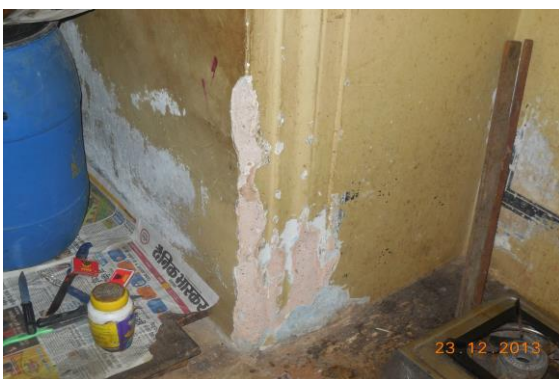
Photo 91

Peeling of Plaster on Wall No. 4 of Room No. 1 (Part 1) of House No.643, Ground Floor

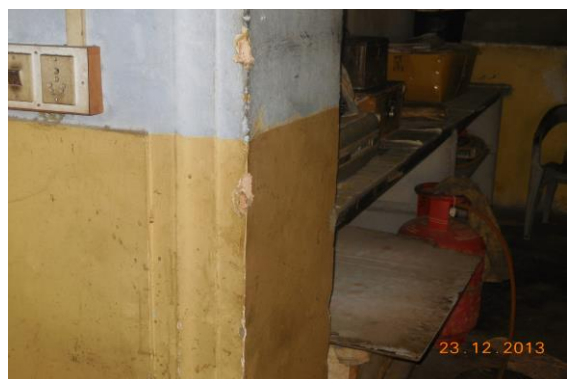
Photo 92

Peeling of Plaster on Wall No. 4 of Room No. 1 (Part 1) of House No.643, Ground Floor

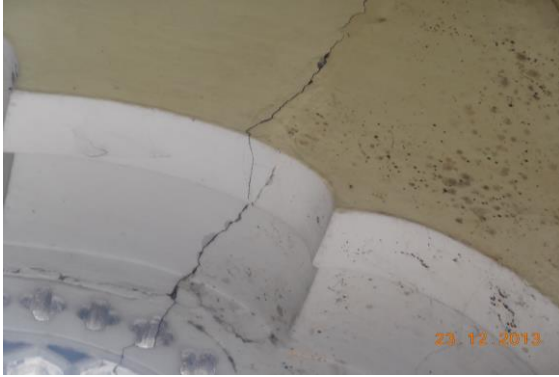
Photo 93

Damaged Portion on Wall No. 4 of House No.643 of House No.643, Ground Floor

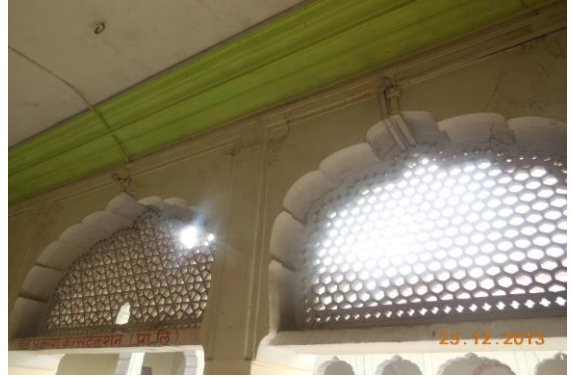
Photo 94

Dampness/Seepage on Wall No. 4 of House No.643 of House No.643, Ground Floor

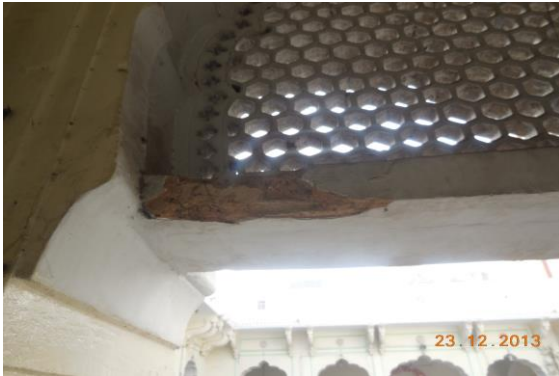
Photo 95

Damaged Portion on Wall No. 4 of House No.643 of House No.643, Ground Floor

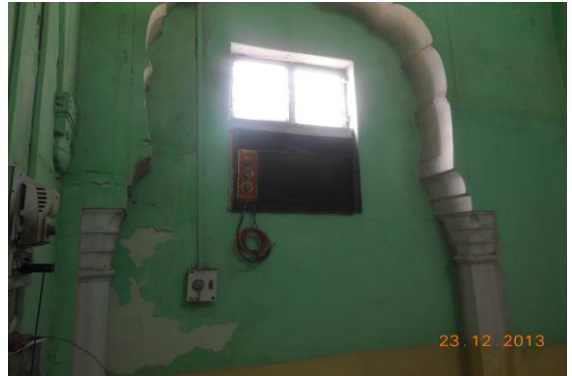
Photo 96

Dampness/Seepage on Wall No. 1 of Room No. 2 (Part 1) of House No.643, Ground Floor

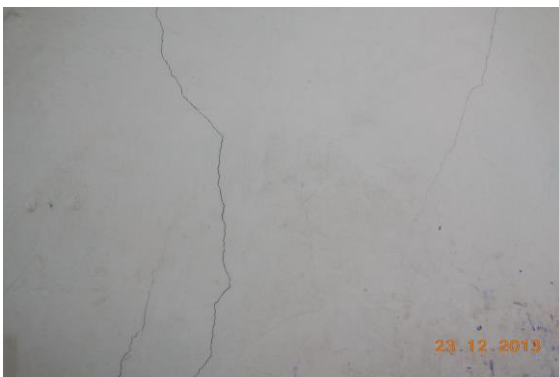
Photo 97

Peeling of Plaster on Wall No. 2 of Room No. 2 (Part 1) of House No.643, Ground Floor

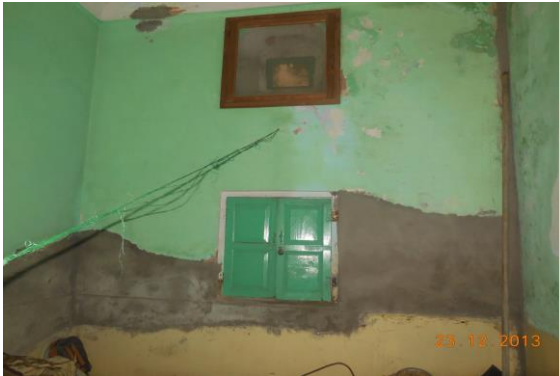
Photo 99

Dampness/Seepage on Wall No. 4 of Room No. 2 (Part 2) of House No.643, Ground Floor

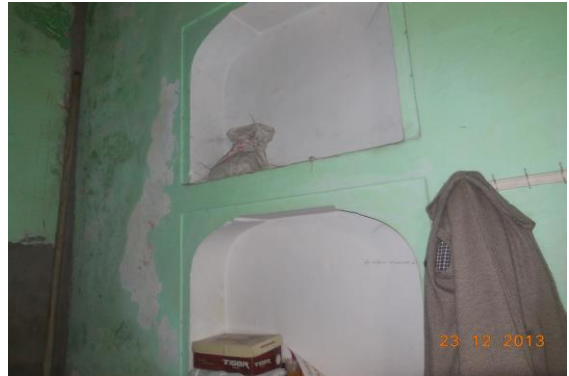
Photo 100

Peeling of Plaster on Wall No. 2 of Room No. 2 (Part 2) of House No.643, Ground Floor

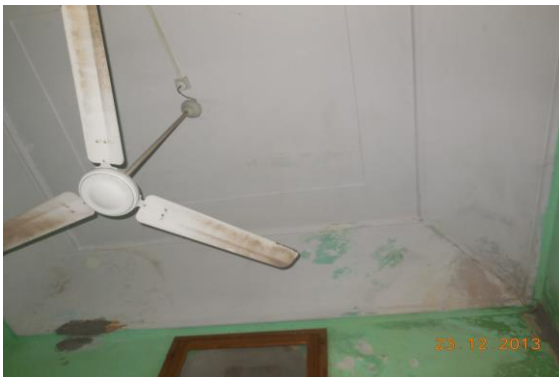
Photo 101

Dampness/Seepage on Roof of Room No. 2 (Part 2) of House No.643, Ground Floor

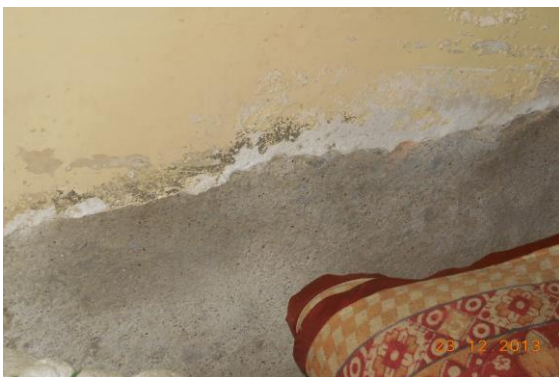
Photo 103

Peeling of Plaster on Wall No. 1 of Room No. 2 (Part 2) of House No.643, Ground Floor

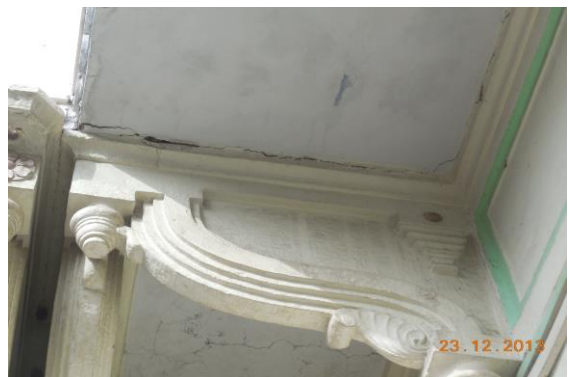
Photo 104

Damaged Portion on Shade of Open Sky of Ground Floor

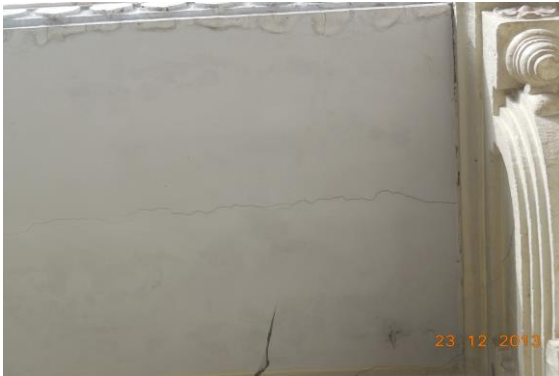
Photo 105

Peeling of Plaster on Shade of Open Sky of Ground Floor

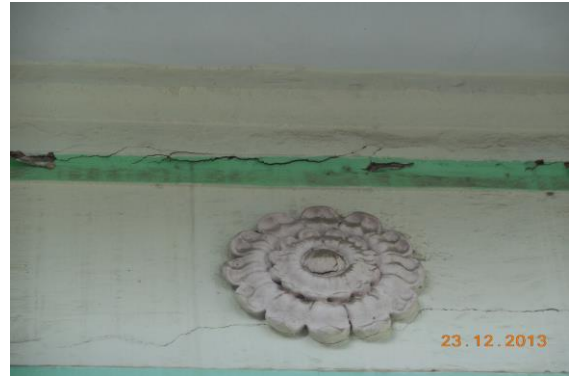
Photo 106

Peeling of Plaster on Wall No. 2 of Open Sky of Ground Floor

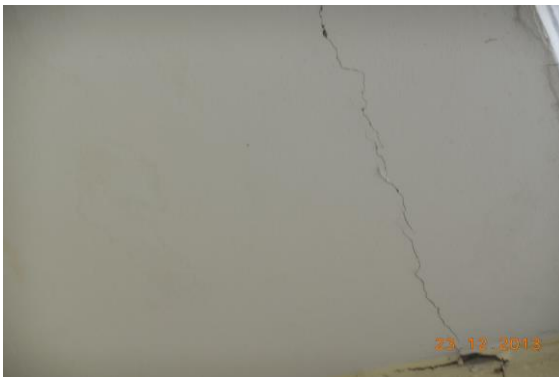
Photo 107

Peeling of Plaster on Wall No. 4 of Open Sky of Ground Floor

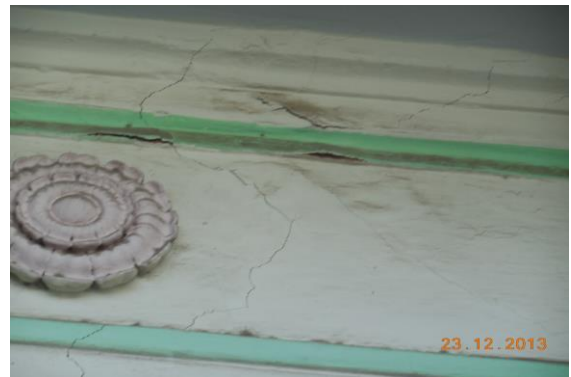
Photo 108

Peeling of Plaster on Wall No. 4 of Open Sky of Ground Floor

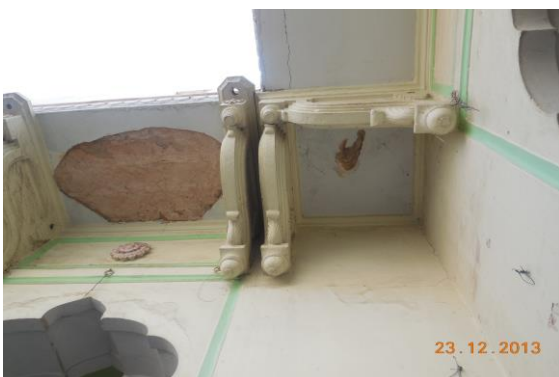
Photo 109

Damaged Portion on Wall No. 1 & Shade of Open Sky of Ground Floor

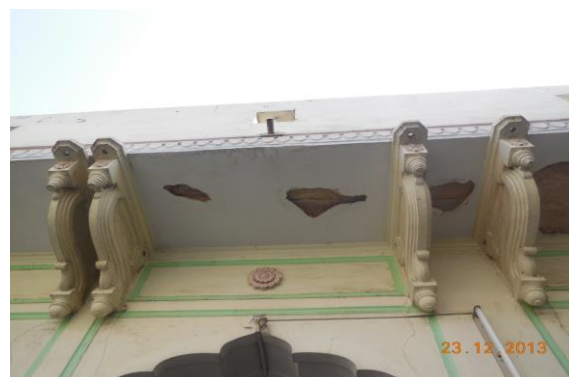
Photo 110

Damaged Portion on Wall No. 1 & Shade of Open Sky of Ground Floor

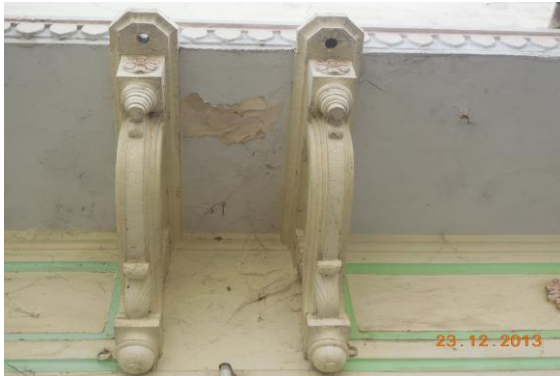
Photo 111

Damaged Portion on Wall No. 1 & Shade of Open Sky of Ground Floor

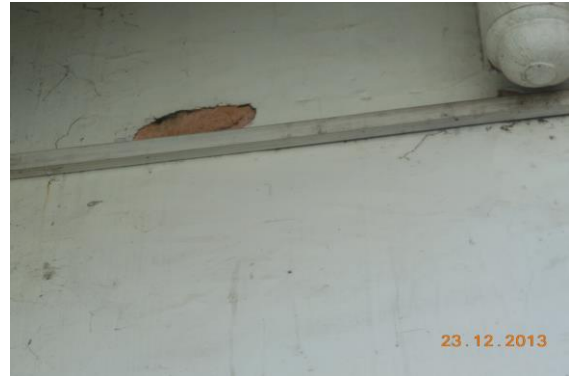
Photo 112

Peeling of Plaster on Wall No. 1 & Shade of Open Sky of Ground Floor

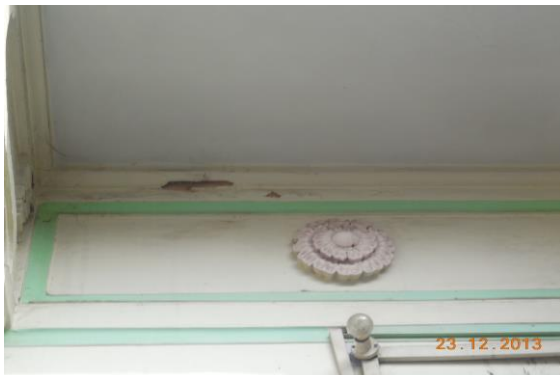
Photo 113

Peeling of Plaster on Wall No. 3 & Shade of Open Sky of Ground Floor

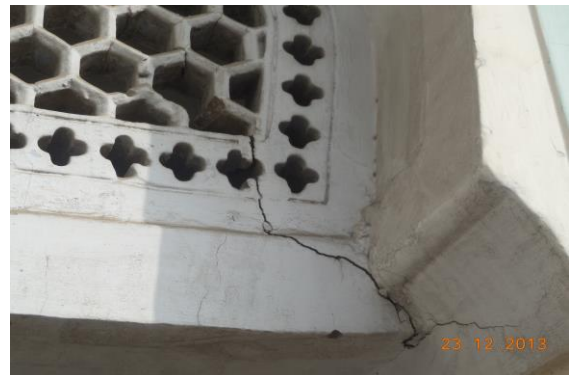
Photo 114

Damaged Portion on Wall No. 3 of Open Sky of Ground Floor

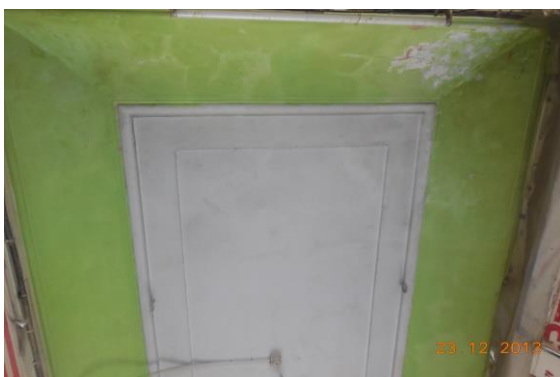
Photo 115

Dampness/Seepage on Roof of Entrance of Ground Floor

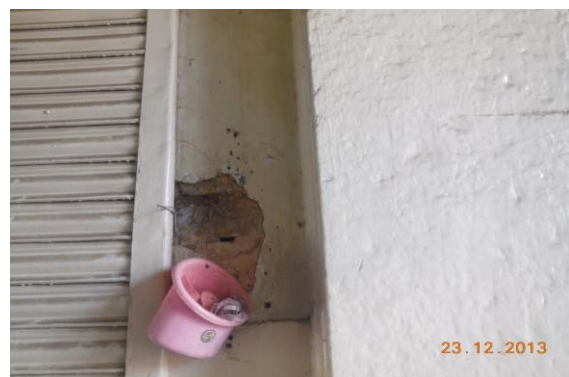
Photo 116

Peeling of Plaster on Wall No. 2 of Entrance of Ground Floor

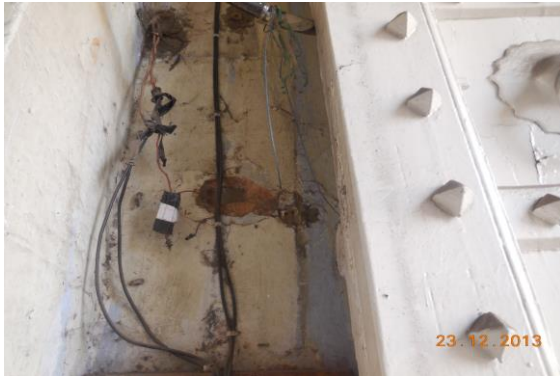
Photo 117
Peeling of Plaster on Wall No. 2 of Entrance of Ground Floor

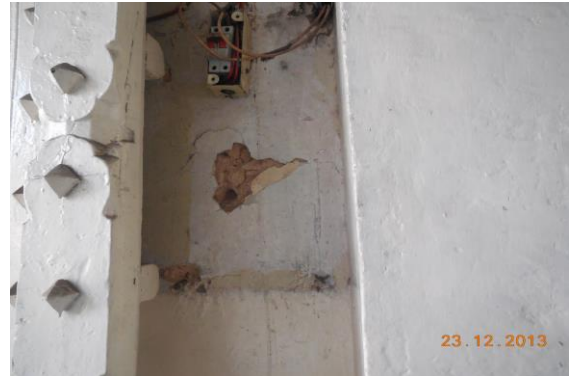
Photo 118
Peeling of Plaster on Wall No. 1 of Entrance of Ground Floor

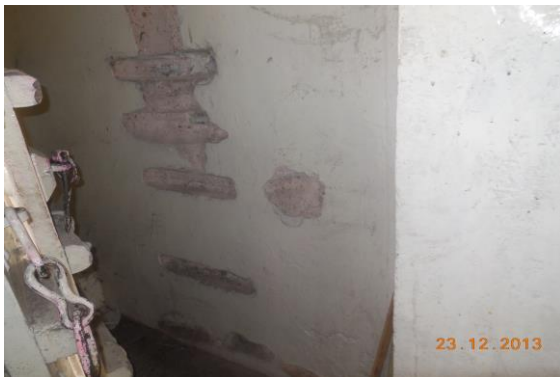
Photo 119
Peeling of Plaster on Wall No. 1 of Entrance of

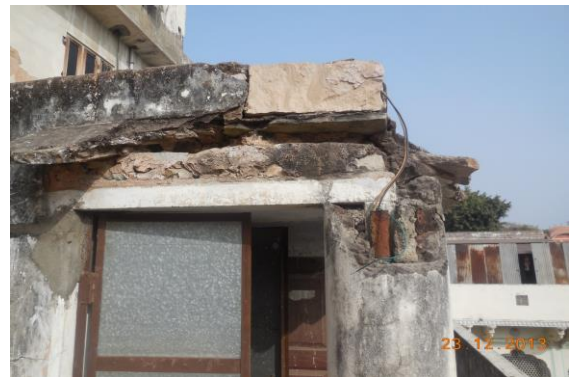
Photo 120
Damaged Portion on of Tower of Terrace

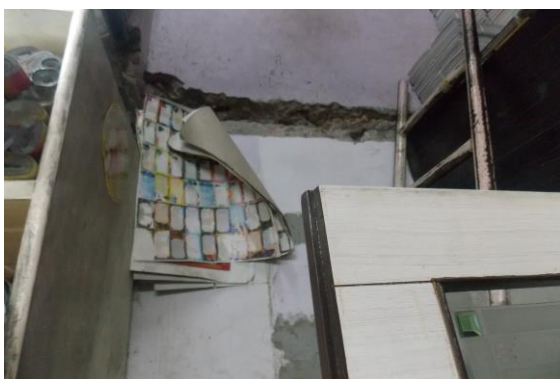
Photo 121
Peeling of Plaster on Wall No. 1 of Shop No.246 of Ground Floor

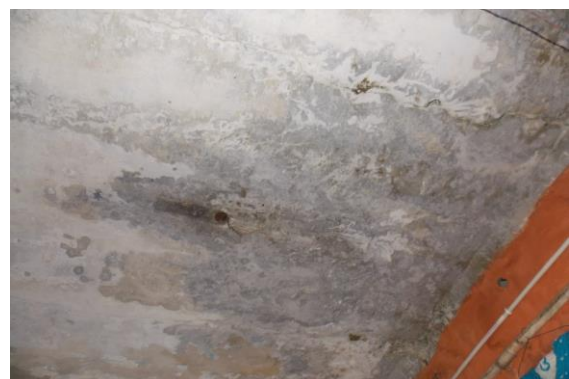
Photo 122
Dampness/Seepage on Roof of Varanda of Shop No.245 of Ground Floor

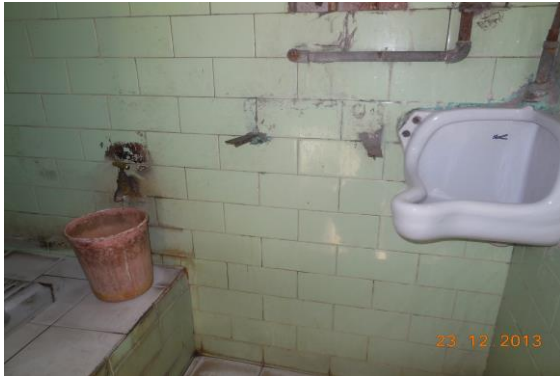
Photo 129
All Walls of Toilet No. 1 of House No.643, Ground Floor

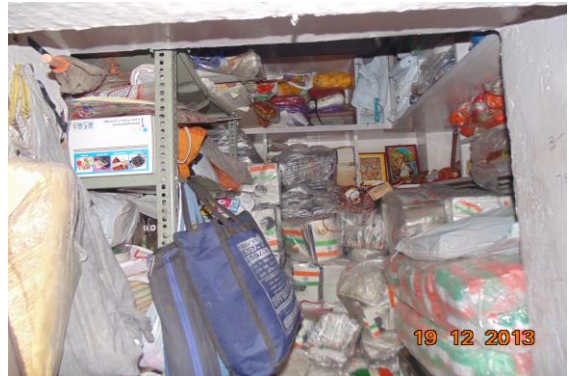
Photo 130
All walls of Part B of Shop Chagan Lal & Sons of Ground Floor Covered With Material

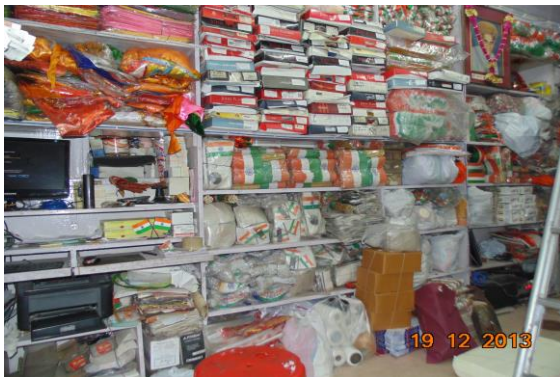
Photo 131
Wall No. 4 of Part A of Shop Chagan Lal & Sons of Ground Floor Covered With Material

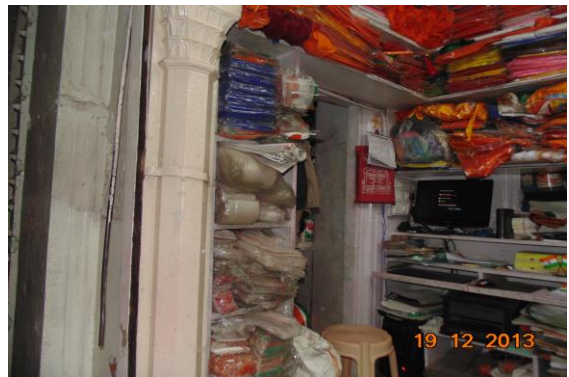
Photo 132
Wall No. 1 of Part A of Shop Chagan Lal & Sons of Ground Floor Covered With Material

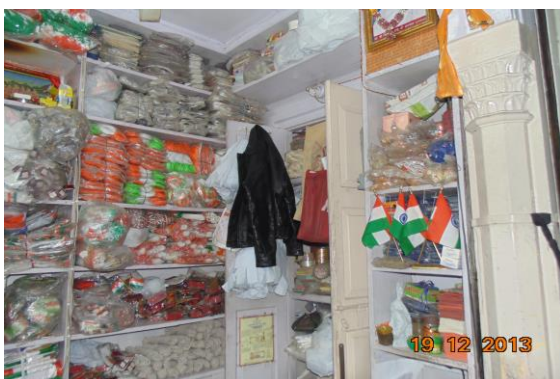
Photo 133
Wall No. 2 of Part A of Shop Chagan Lal & Sons of Ground Floor Covered With Material

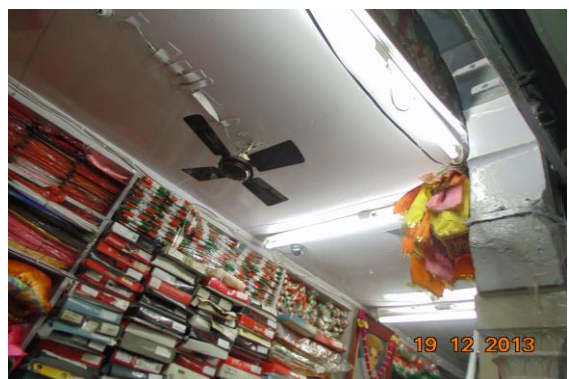
Photo 134
Roof of Part A of Shop Chagan Lal & Sons of Ground Floor Covered With Wooden Ceiling

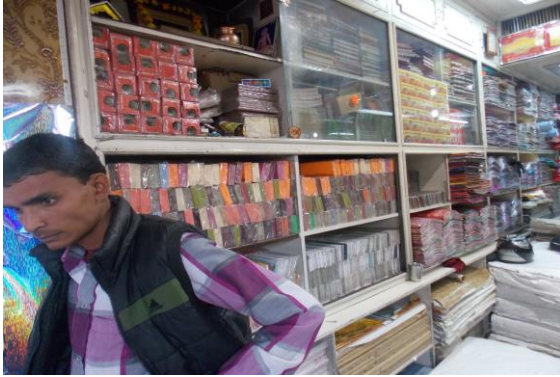
Photo 135

Wall No. 1 of Shop No.246 of Ground Floor Covered With Material

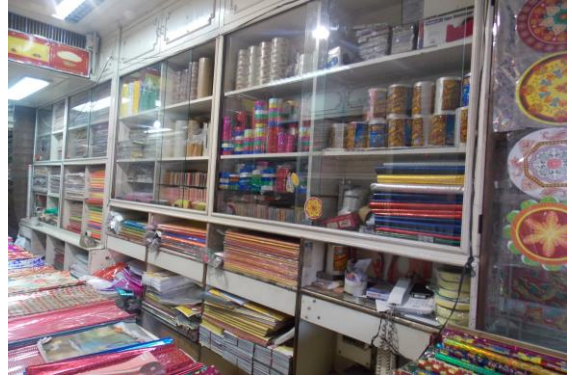
Photo 136

Wall No. 2 of Shop No.246 of Ground Floor Covered With Material

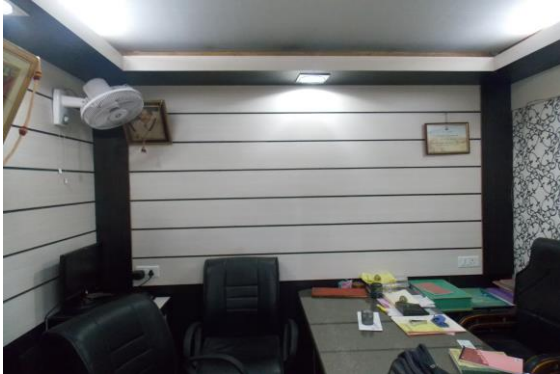
Photo 137

Wall No. 4 of Shop No.246 of Ground Floor Covered With Wooden Work

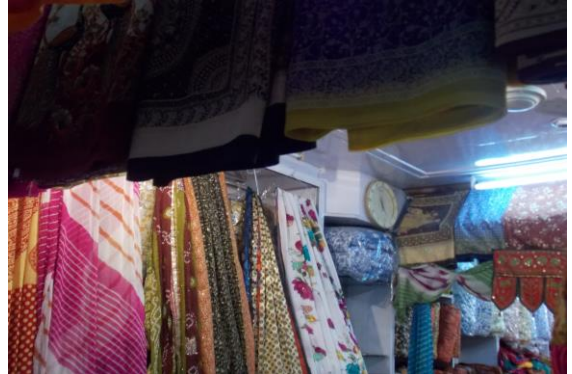
Photo 138

Wall No. 1 of Shop No.245 of Ground Floor Covered With Material

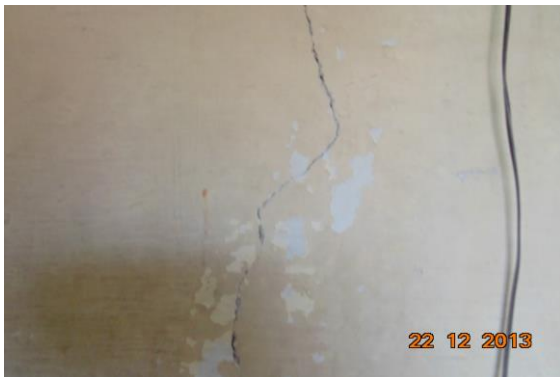
Photo 3
Inclined Crack on Wall No. 1 of Room No. 1, Second Floor
Approx. Width = 0.6mm, Approx. Length = 2.5m.
Distance from Wall No.1 = 0.7m, Height from Floor = 0m.

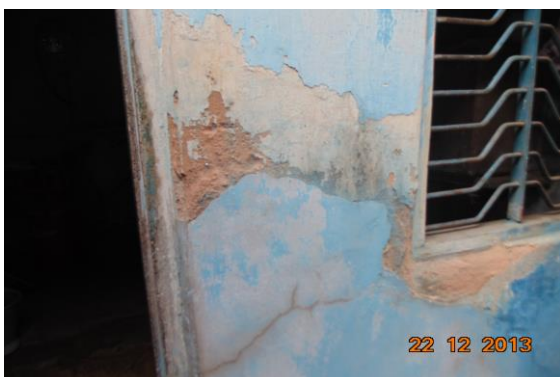
Photo 4
Peeling of Plaster on Wall No. 1 of Passage of First Floor

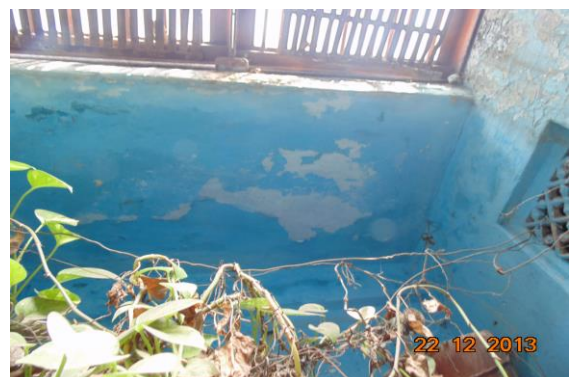
Photo 5
Peeling of Plaster on Roof of Passage of First Floor

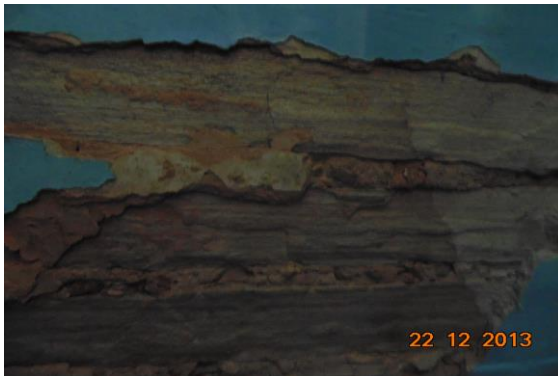
Photo 6
Peeling of Plaster on Roof of Room No. 3 of First Floor

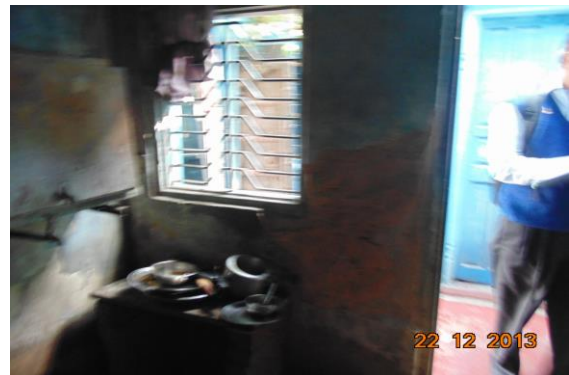
Photo 9
Peeling of Plaster on Wall No. 3 of Room No. 3 of First Floor

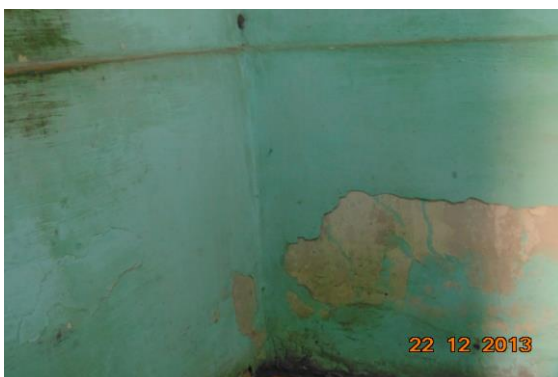
Photo 10
Peeling of Plaster on Wall No. 4 of Temple of First Floor

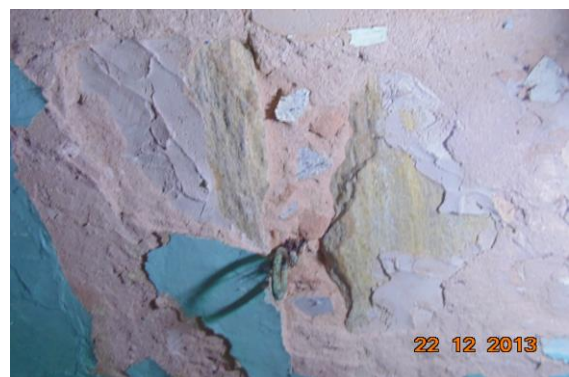
Photo 11
Peeling of Plaster on Roof of Temple of First Floor

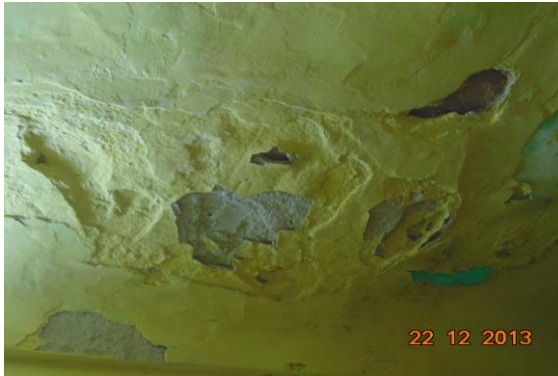
Photo 12
Peeling of Plaster on Roof of Room No. 2 of First Floor

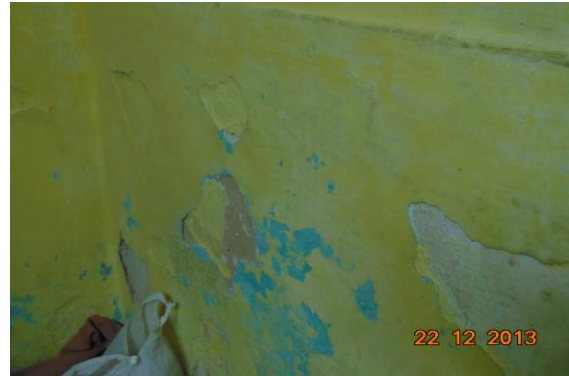
Photo 13
Peeling of Plaster on Wall No. 2 of Room No. 2 of First Floor

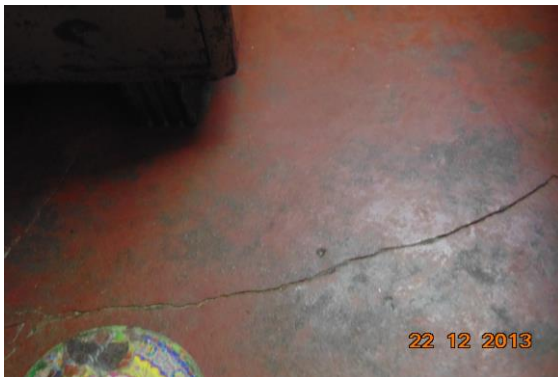
Photo 14
Peeling of Plaster on Floor of Room No. 2 of First Floor

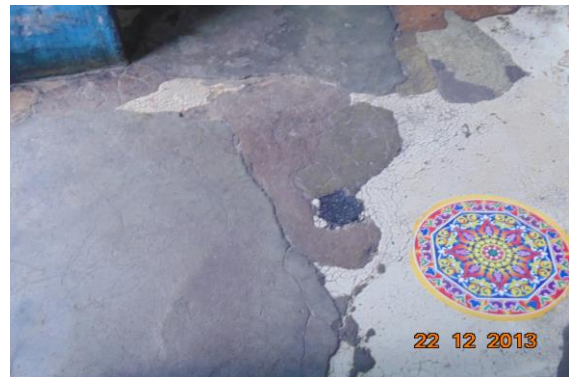
Photo 15
Peeling of Plaster on Floor of Lobby of First Floor

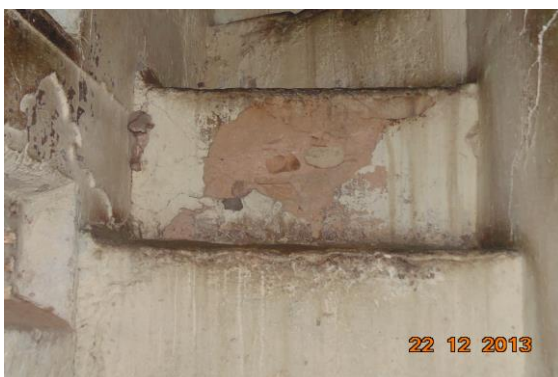
Photo 16
Peeling of Plaster on Steps of Staircase FF to SF of First Floor

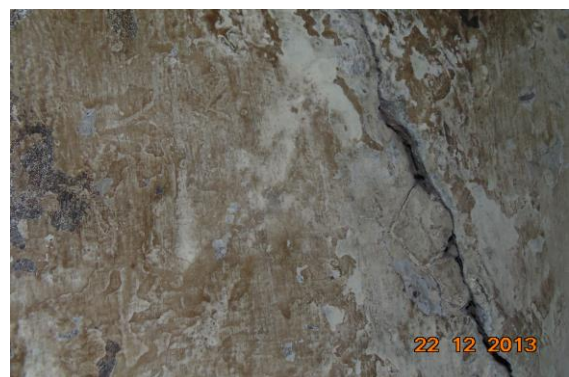
Photo 17
Peeling of Plaster on Wall No. 1 of Staircase FF to SF of First Floor

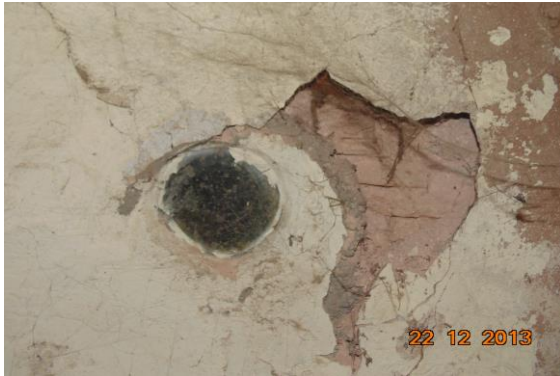
Photo 18

Peeling of Plaster on Wall No. 3 of Staircase FF to SF of First Floor
