Pre Building Condition Survey Report

Name and Address of Structure :	Choti Chopar to Badi Chopar (Down Line)
---------------------------------	---

Name of the Project	Contract JMRC-UG1B “Design and Construction of Tunnel between Chandpole and Badi Chouper and reverse line by Shield TBM, Underground Metro Stations at Choti Chouper and Badi Chouper by Cut and Cover Methods on East West Corridor of Jaipur Metro Rail Corporation Limited .”	
Owner :

Pre Building Condition Survey Report Choti Chopar to Badi Chopar (Down Line)

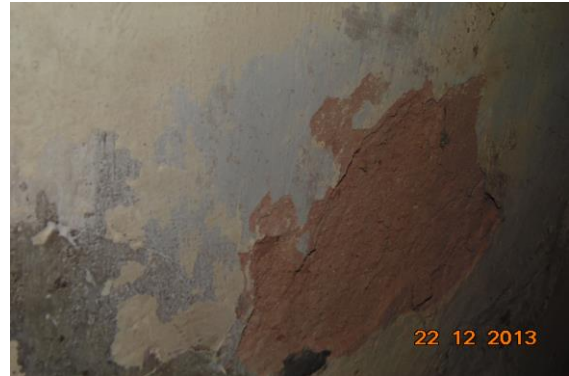
Photo 19

Peeling of Plaster on Wall No. 2 of Staircase FF to SF of First Floor

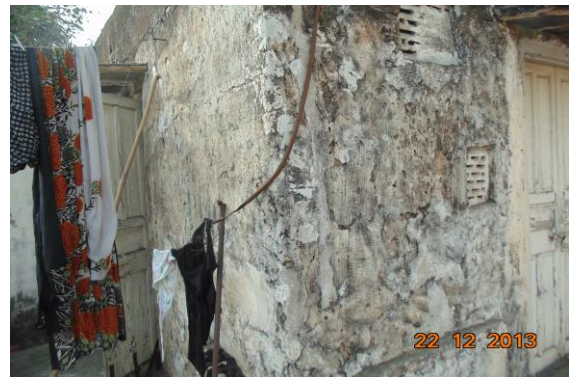
Photo 21

Peeling of Plaster on Outer Wall of Room No. 1 of Second Floor

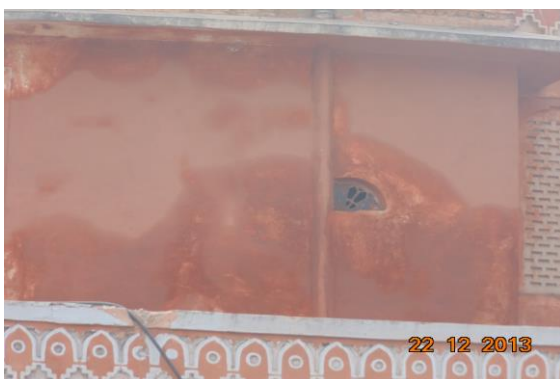
Photo 22

Dampness/Seepage on Front Side of H. No.646 of Second Floor

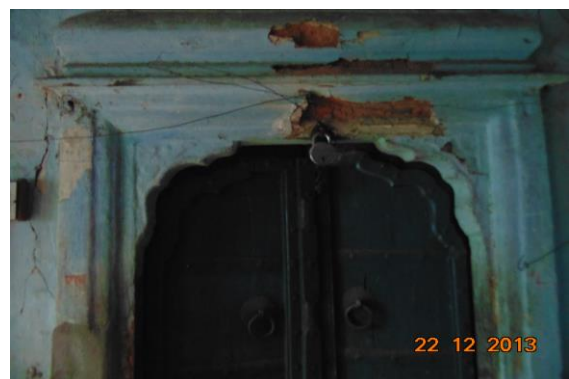
Photo 23

Room No. 4 of First Floor

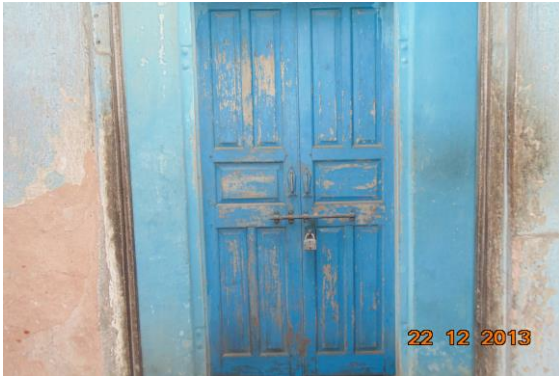
Photo 24
Room No. 1 of First Floor

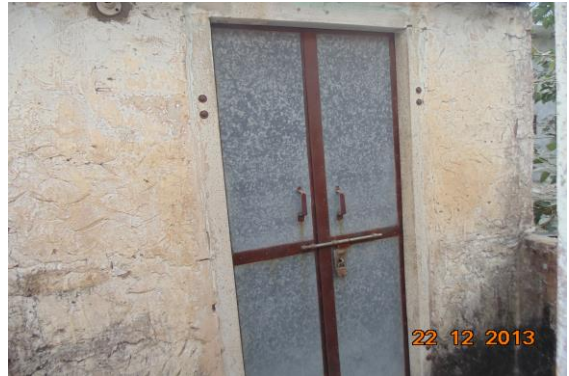
Photo 25
Kitchen of Second Floor Locked

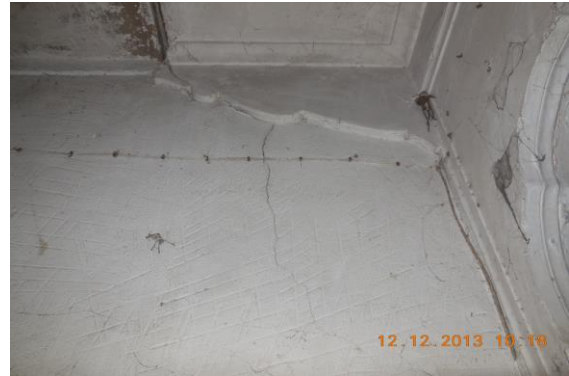
Photo 14
Inclined Crack on Wall No. 1 of Shop No. 3, Ground Floor, Approx. Width = 5mm, Approx. Length = 1.5m.
Distance from w3 = 1.3m, Height from Floor = 2.2m.

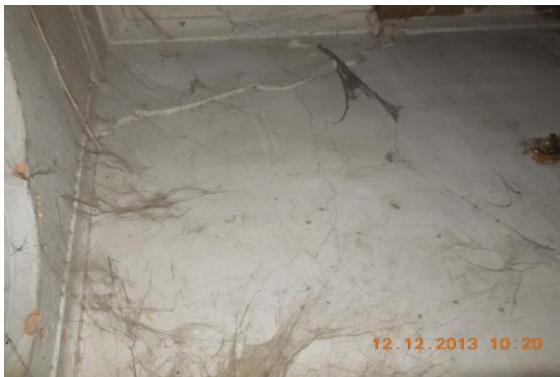
Photo 15
Inclined Crack on Wall No. 6 of Shop No. 3, Ground Floor, Approx. Width = 5mm, Approx. Length = 1.5m.
Distance from w3 = 1.3m, Height from Floor = 2.2m.

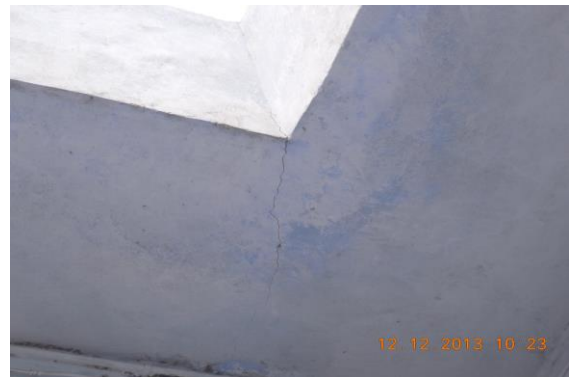
Photo 16
Inclined Crack on Wall No. 3 of Open Area, House No. 651, Ground Floor, Approx. Width = 7mm, Approx. Length = 1m.
Distance from = m, Height from Floor = m.

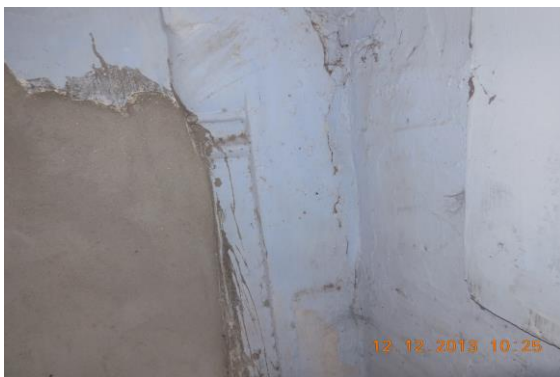
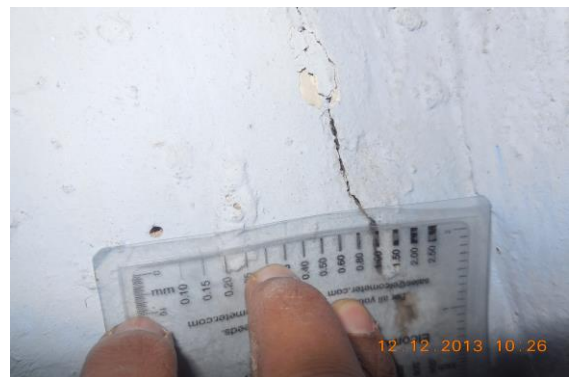
Photo 17
Inclined Crack on Wall No. 4 of Lobby, House No. 651, Ground Floor, Approx. Width = 1mm, Approx. Length = 0.4m.
Distance from W2 = 0.03m, Height from Floor = 1.1m.

Photo 17A
Inclined Crack on Wall No. 4 of Lobby, House No. 651, Ground Floor, Approx. Width = 1mm, Approx. Length = 0.4m.
Distance from W2 = 0.03m, Height from Floor = 1.1m.

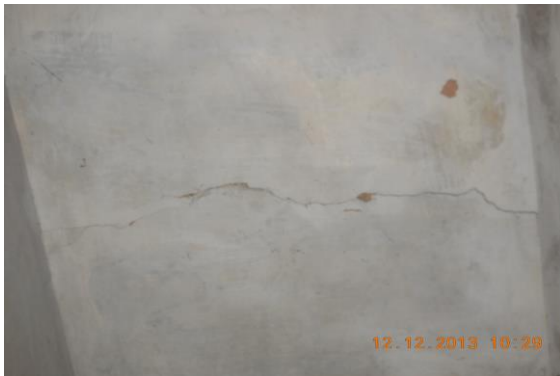
Photo 18

Horizontal Crack on Wall No. 2 of Stair Case GF to FF, House No. 651, Ground Floor, Approx. Width = 0.8mm, Approx. Length = 1m. Distance from w2 = 0.8m, Height from Floor = 4m.

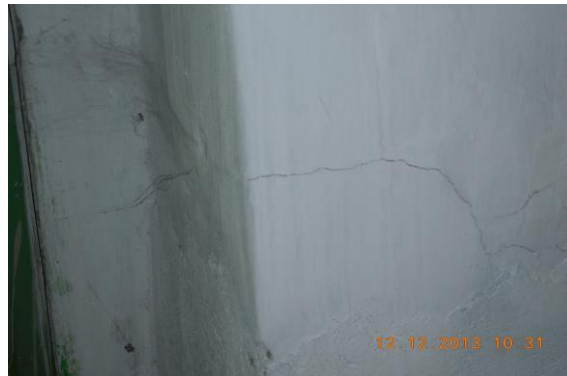
Photo 19

Inclined Crack on Wall No. 3 of Room No. 1, Ground Floor, Approx. Width = 0.3mm, Approx. Length = 0.35m. Distance from w2 = 1.35m, Height from Floor = 1.3m.

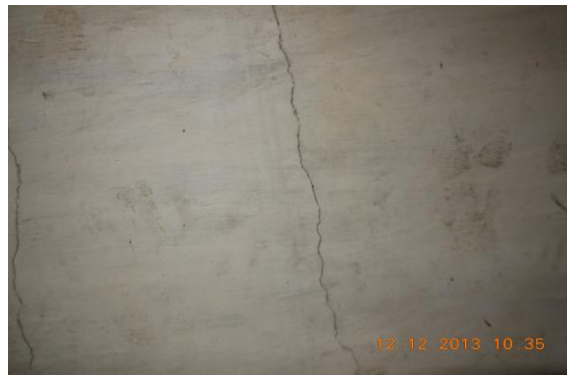
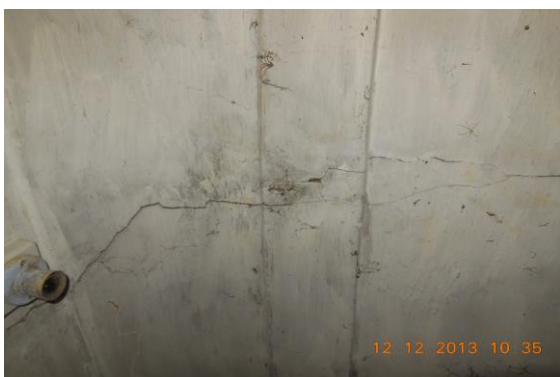
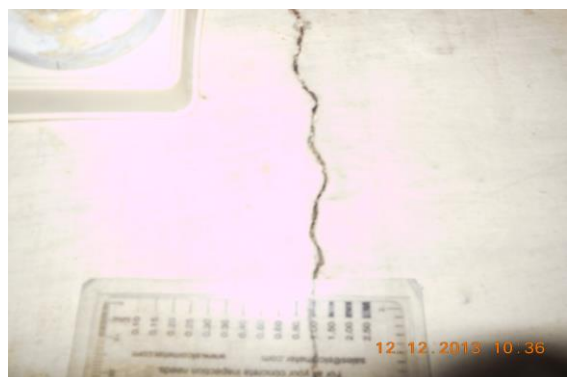
Photo 20

Inclined Crack on Wall No. 8 & Roof of Verandah, House No. 651, Ground Floor, Approx. Width = 1mm, Approx. Length = 4m. Distance from w1 = 6.5m, Height from Floor = 0m.

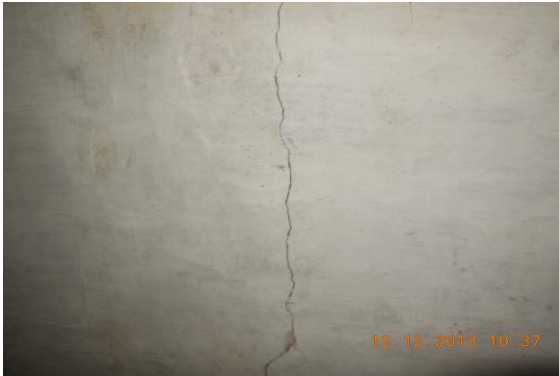
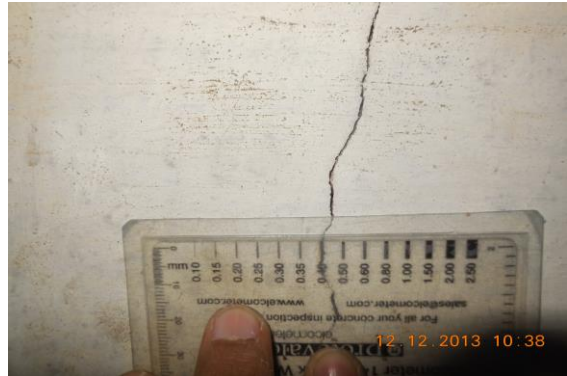
Photo 21

Inclined Crack on Wall No. 8 of Verandah, House No. 651, Ground Floor, Approx. Width = 0.4mm, Approx. Length = 4m.
Distance from w1 = 6.3m, Height from Floor = 0m.

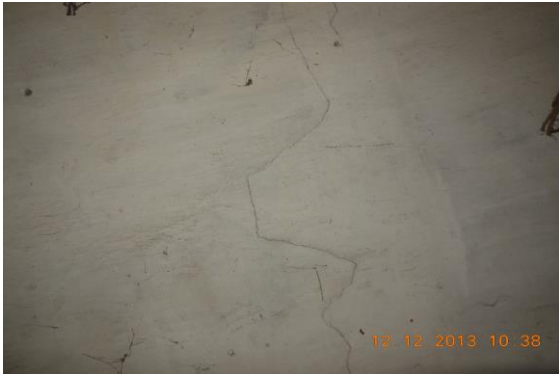
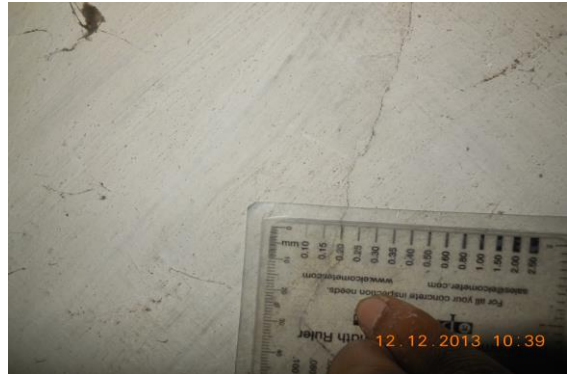
Photo 22

Inclined Crack on Wall No. 4 of Verandah, House No. 651, Ground Floor, Approx. Width = 0.2mm, Approx. Length = 2.5m.
Distance from w1 = 6m, Height from Floor = 0m.

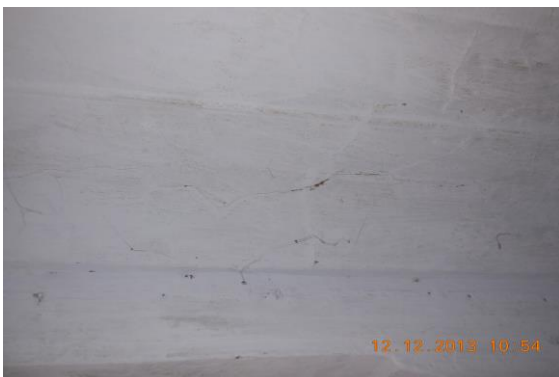
Photo 23

Horizontal Crack on Roof of Verandah, House No. 651, Ground Floor, Approx. Width = 0.4mm, Approx. Length = 1.5m.
Distance from w3 = 0.1m, Height from Floor = 2.4m.

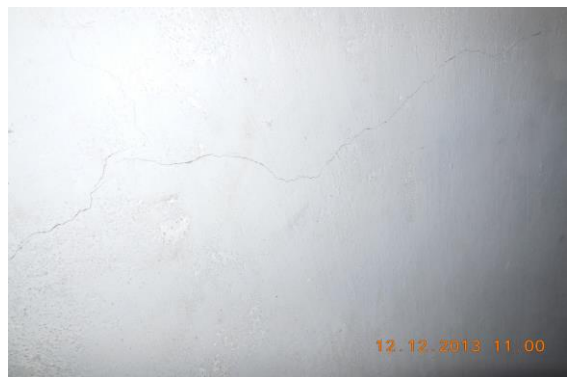
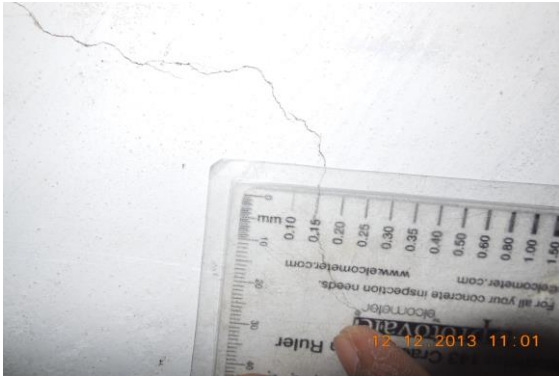
Photo 24

Horizontal Crack on Wall No. 1 of Stair Case GF to FF, House No. 651, Ground Floor, Approx. Width = 0.15mm, Approx. Length = 0.8m.
Distance from w3 = 0.9m, Height from Floor = 0.3m.

Horizontal Crack on Wall No. 1 of Stair Case GF to FF, House No. 651, Ground Floor, Approx. Width = 0.15mm, Approx. Length = 0.8m. Distance from w3 = 0.9m, Height from Floor = 0.3m.

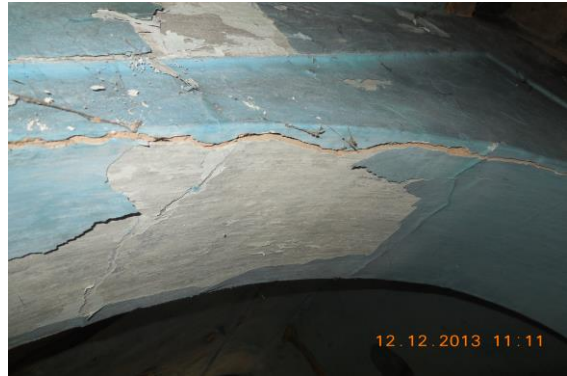
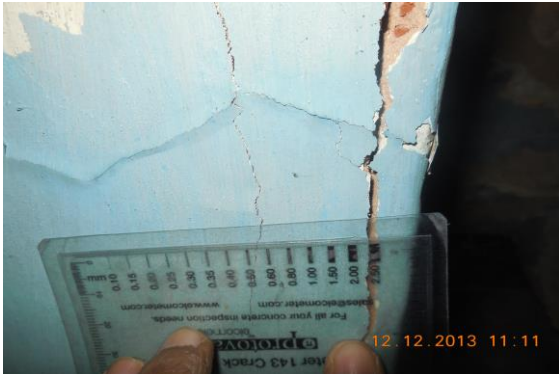
Photo 25

Inclined Crack on Roof of Gate, House No. 651, First Floor, Approx. Width = 2.5mm, Approx. Length = 0.7m. Distance from w1 = 0.12m, Height from Floor = 1.3m.

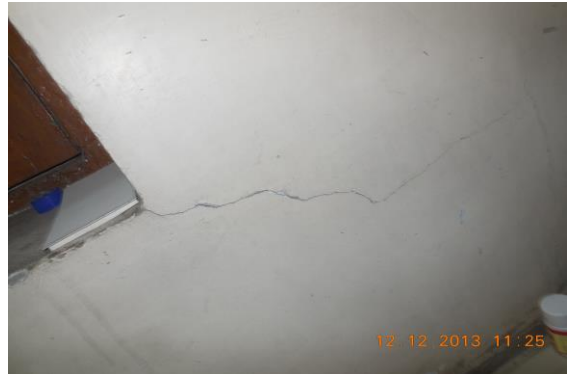
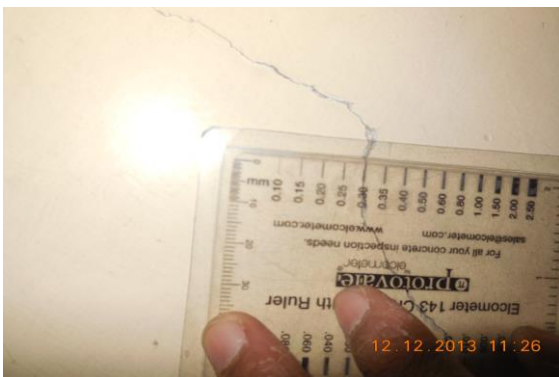
Photo 26

Inclined Crack on Wall No. 1 of , House No. 651, First Floor, Approx. Width = 0.3mm, Approx. Length = 1m. Distance from W4 = 1m, Height from Floor = 0.35m.

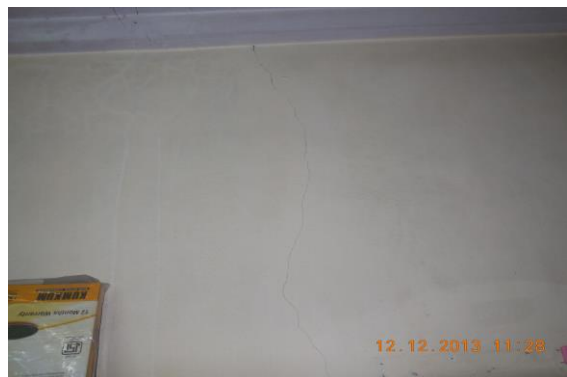
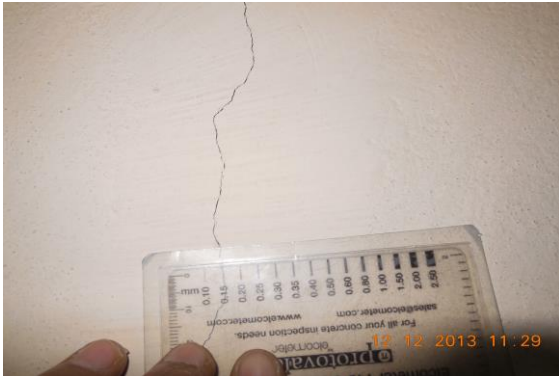
Photo 27

Inclined Crack on Wall No. 1 of Room No. 9, House No. 651, First Floor, Approx. Width = 0.5mm, Approx. Length = 1.3m. Distance from w4 = 1.4m, Height from Floor = 1.2m.

Inclined Crack on Wall No. 1 of Room No. 9, House No. 651, First Floor, Approx. Width = 0.5mm, Approx. Length = 1.3m.
Distance from W4 = 1.4m, Height from Floor = 1.2m.

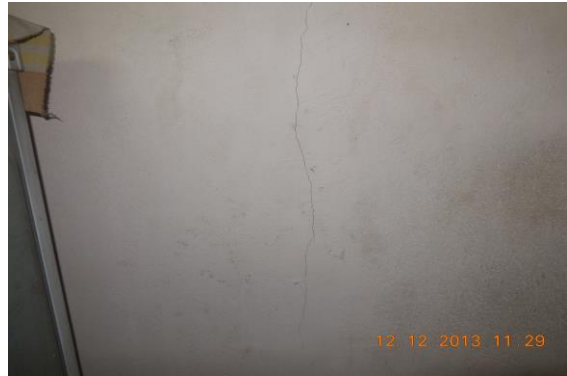
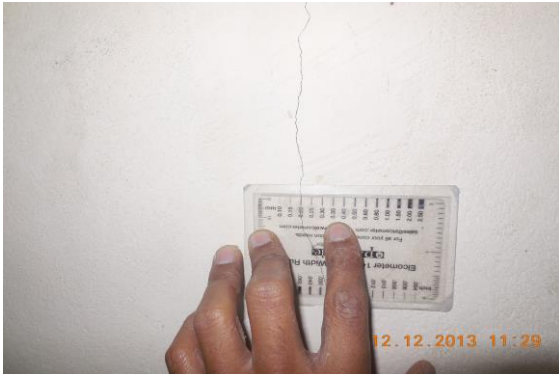
Photo 28

Inclined Crack on Wall No. 1 of Room No. 9, House No. 651, First Floor, Approx. Width = 0.2mm, Approx. Length = 1m.
Distance from W4 = 1.3m, Height from Floor = 0.2m.

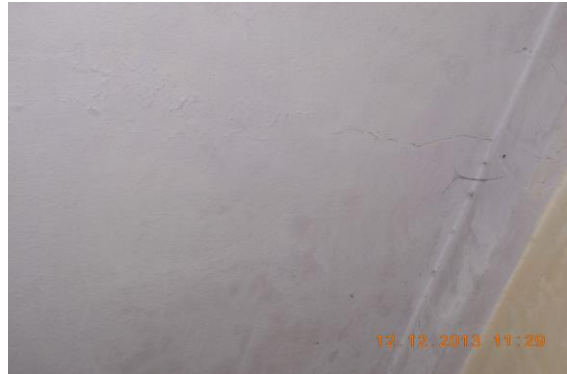
Photo 29

Inclined Crack on Wall No. 2 & Roof of Room No. 9, House No. 651, First Floor, Approx. Width = 0.35mm, Approx. Length = 3m.
Distance from W4 = 1.4m, Height from Floor = 2.3m.

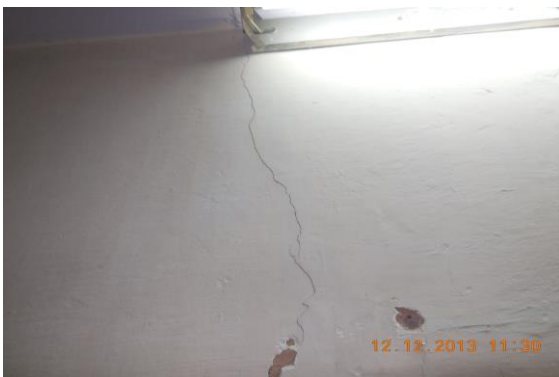
Photo 29A

Inclined Crack on Wall No. 2 & Roof of Room No. 9, House No. 651, First Floor, Approx. Width = 0.35mm, Approx. Length = 3m.
Distance from W4 = 1.4m, Height from Floor = 2.3m.

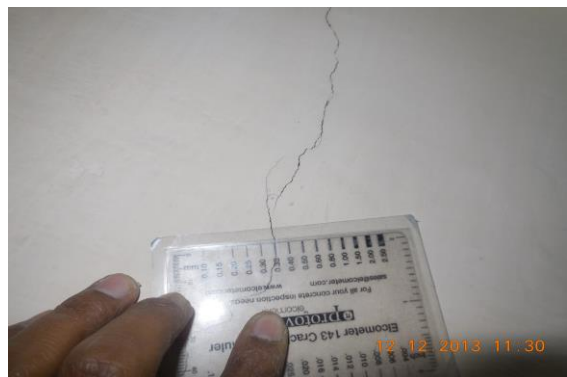
Photo 29A

Inclined Crack on Wall No. 2 & Roof of Room No. 9, House No. 651, First Floor, Approx. Width = 0.35mm, Approx. Length = 3m.
Distance from W4 = 1.4m, Height from Floor = 2.3m.

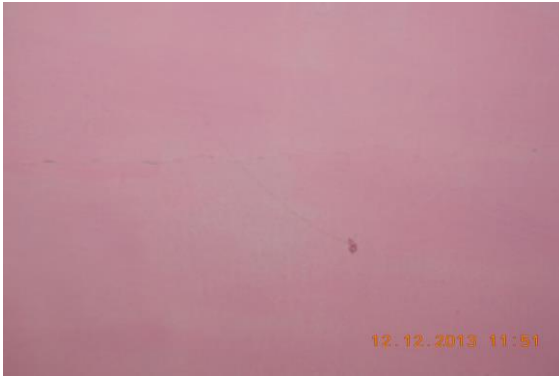
Photo 30

Horizontal Crack on Roof of Kitchen, House No. 651, Second Floor, Approx. Width = 0.2mm, Approx. Length = 2m. Distance from w2 = 1.3m, Height from Floor = 3m.

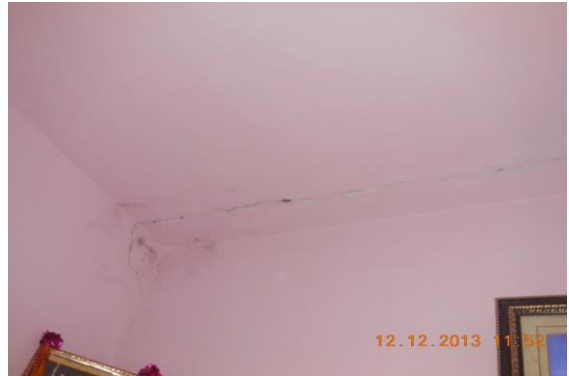
Photo 31

Inclined Crack on Wall No. 4 & Roof of Hall No. 2, House No. 651, Second Floor, Approx. Width = 3mm, Approx. Length = 3m. Distance from w2 = 0.15m, Height from Floor = 3m.

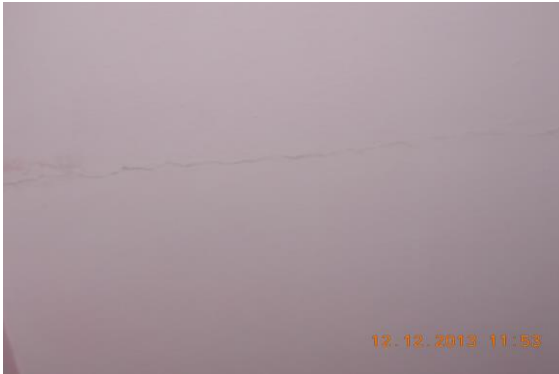
Photo 32

Horizontal Crack on Roof of Hall No. 2, House No. 651, Second Floor, Approx. Width = 0.35mm, Approx. Length = 1m. Distance from W1 = 1.4m, Height from Floor = 3m.

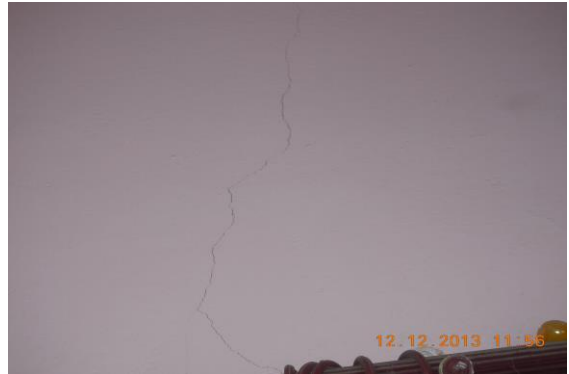
Photo 33

Inclined Crack on Wall No. 4 of Room No. 3, House No. 651, Second Floor, Approx. Width = 0.2mm, Approx. Length = 1m. Distance from W1 = 1.2m, Height from Floor = 2.2m.

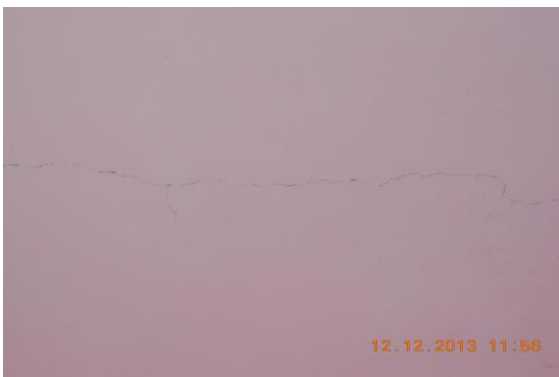
Photo 34

Horizontal Crack on Roof of Room No. 3, House No. 651, Second Floor, Approx. Width = 0.25mm, Approx. Length = 1.5m. Distance from W1 = 0.25m, Height from Floor = 3m.

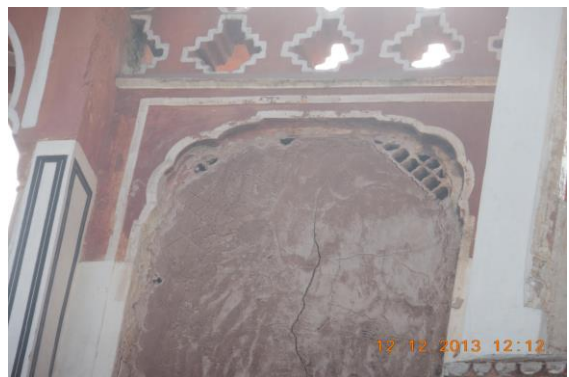
Photo 35

Vertical Crack on Sunshade of House No. 651, Second Floor, Approx. Width = 2mm, Approx. Length = 0.8m. Distance from L/S wall = 9m, Height from Floor = 8m.

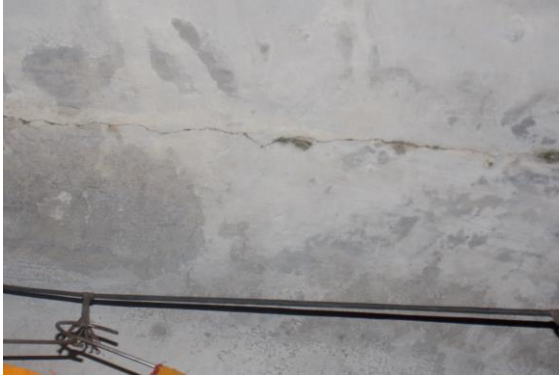
Photo 36

Horizontal Crack on Roof of Varanda of Shop No.238, Ground Floor, Approx. Width = 0.25mm, Approx. Length = 2.5m.
Distance from Left side External Column = Backside, Height from Floor = 3m.

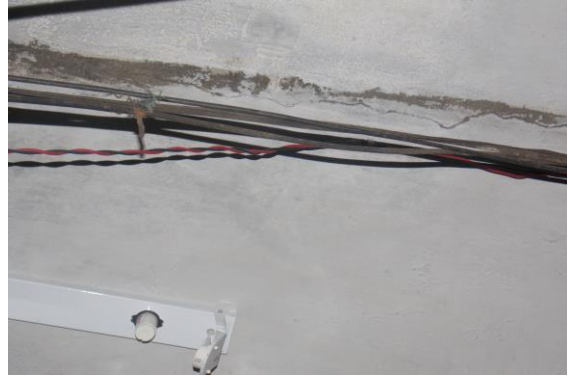
Photo 37

Horizontal Crack on Roof of Varanda of Shop No.235, Ground Floor, Approx. Width = 2mm, Approx. Length = 2.5m.
Distance from Left side External Column = Backside, Height from Floor = 3m.

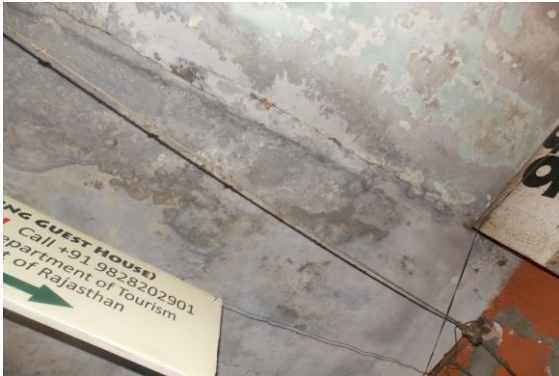
Photo 38

Horizontal Crack on Roof of Varanda of Shop No.236, Ground Floor, Approx. Width = 3mm, Approx. Length = 2.5m.
Distance from Left side External Column = Backside, Height from Floor = 3m.

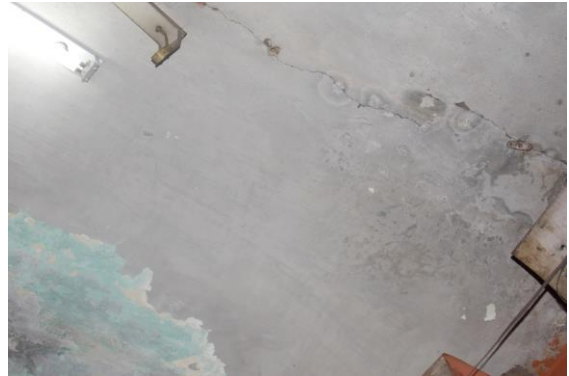
Photo 39

Horizontal Crack on Roof of Varanda of Shop No.237, Ground Floor, Approx. Width = 1.5mm, Approx. Length = 2.5m.
Distance from Left side External Column = Backside, Height from Floor = 3m.

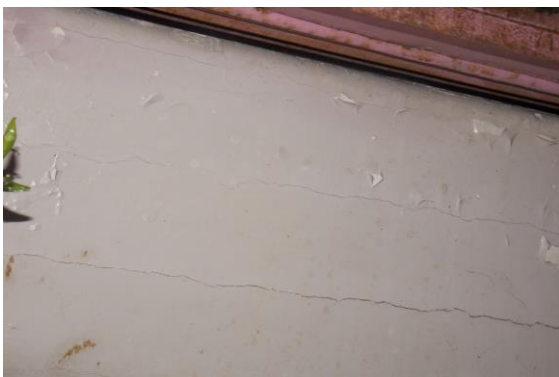
Photo 40

Horizontal Crack on Roof of Varanda of Shop No.237, Ground Floor, Approx. Width = 1mm, Approx. Length = 3.2m.
Distance from = Corner Wall No.1 & 2m, Height from Floor = 2.8m.

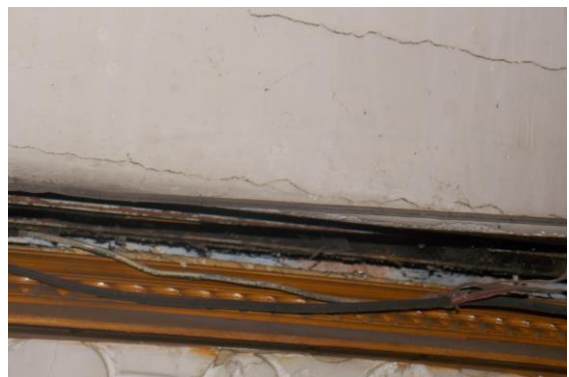
Photo 41

Horizontal Crack on Roof of Varanda of Shop No.237, Ground Floor, Approx. Width = 1mm, Approx. Length = 1.3m.
Distance from Wall No.1 = 1.5m, Height from Floor = 2.8m.

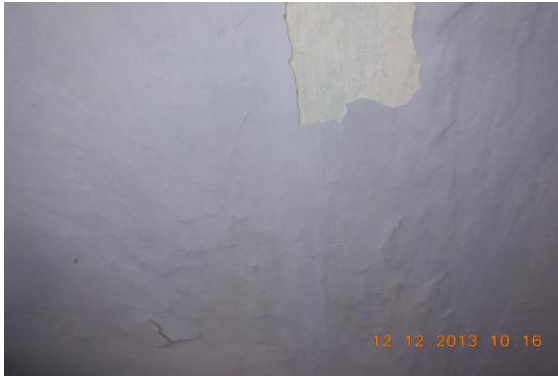
Photo 42
Peeling of Plaster on Roof of Shop No. 2 of Ground Floor

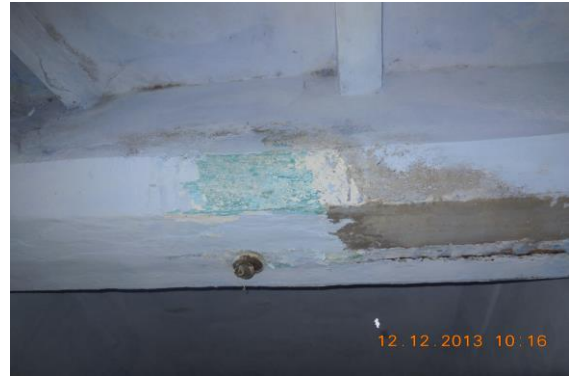
Photo 43
Dampness/Seepage on Roof of Shop No. 2 of Ground Floor

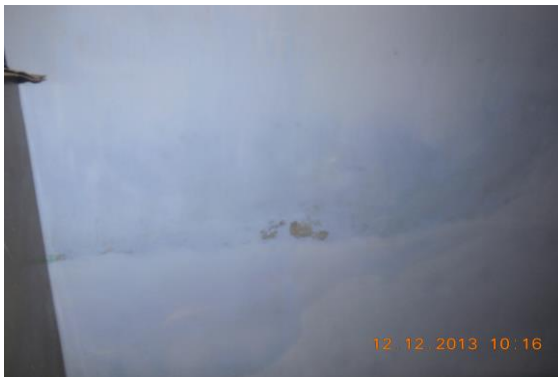
Photo 44
Dampness/Seepage on Wall No. 3 of Shop No. 2 of Ground Floor

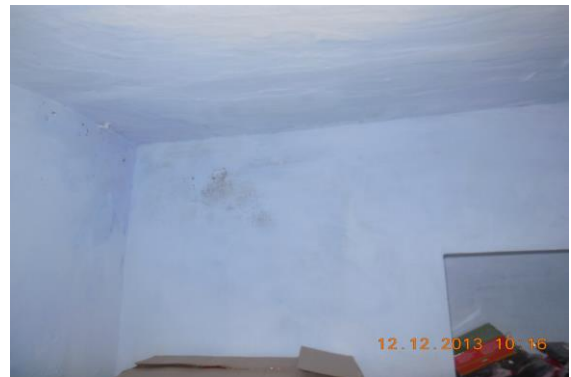
Photo 45
Dampness/Seepage on Wall No. 1 of Shop No. 2 of Ground Floor

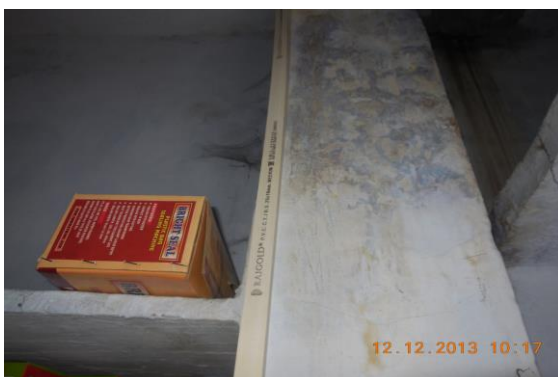
Photo 46
Dampness/Seepage on Wall No. 4 of Shop No. 2 of Ground Floor

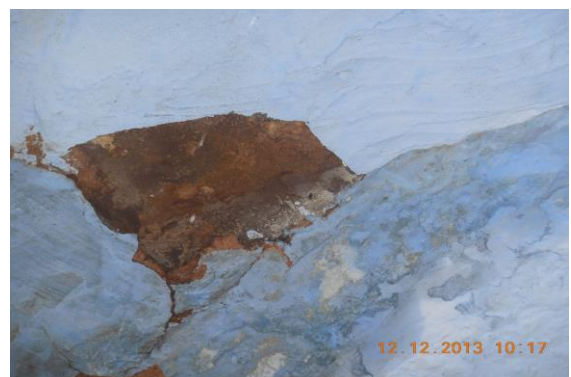
Photo 47
Dampness/Seepage on Roof of Shop No. 2 of Ground Floor

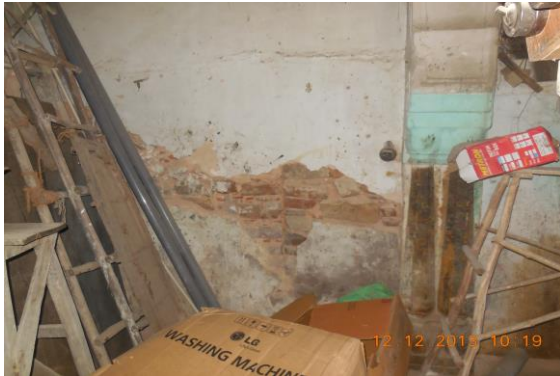
Photo 48

Dampness/Seepage on Wall No. 2 of Shop No. 3 of Ground Floor

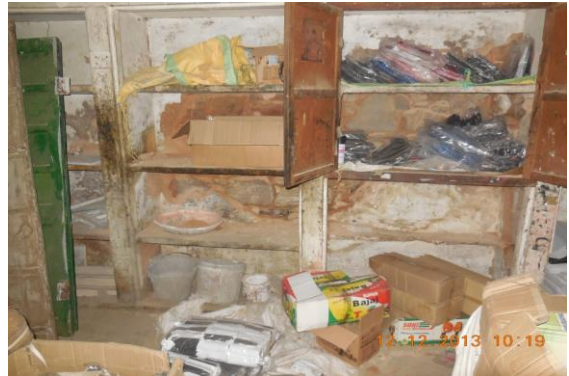
Photo 49

Dampness/Seepage on Wall No. 4 of Shop No. 3 of Ground Floor

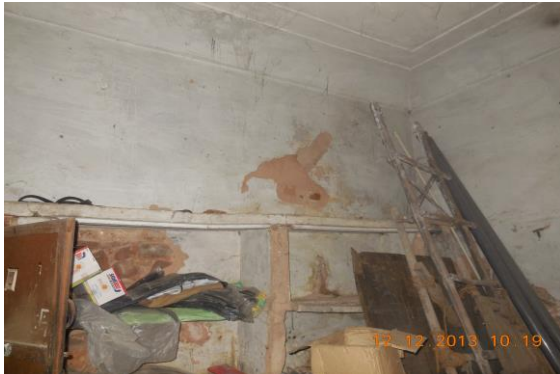
Photo 50

Dampness/Seepage on Wall No. 4 of Shop No. 3 of Ground Floor

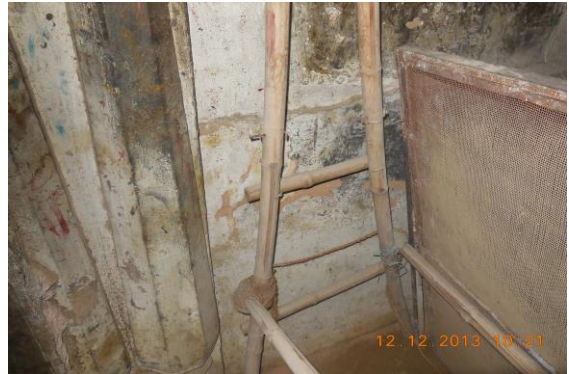
Photo 51

Peeling of Plaster on Wall No. 5 of Shop No. 3 of Ground Floor

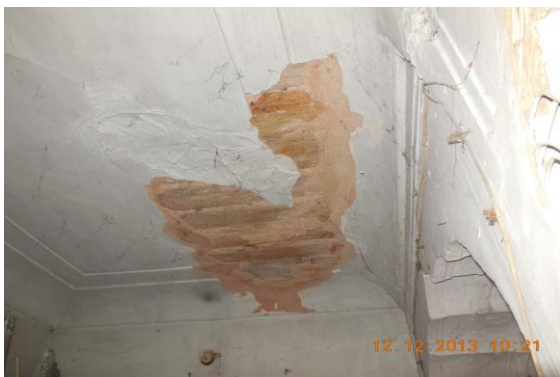
Photo 52

Dampness/Seepage on Roof of Shop No. 3 of Ground Floor

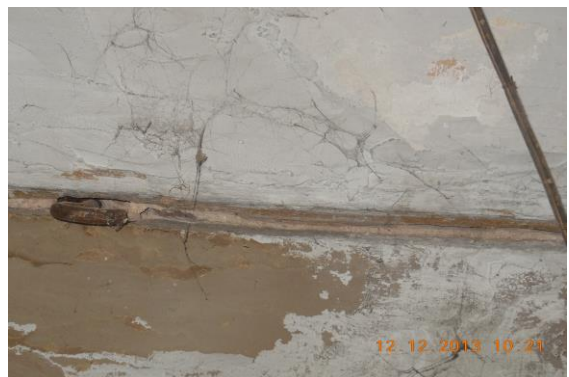
Photo 53

Dampness/Seepage on Roof of Shop No. 3 of Ground Floor

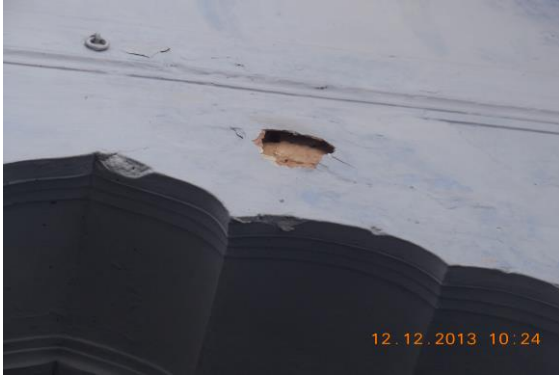
Photo 54

Peeling of Plaster on Wall No. 4 of Open Area of House No. 651, Ground Floor

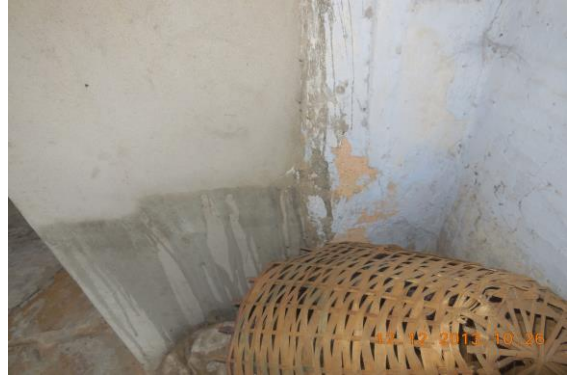
Photo 55

Peeling of Plaster on Wall No. 4 of Lobby of House No. 651, Ground Floor

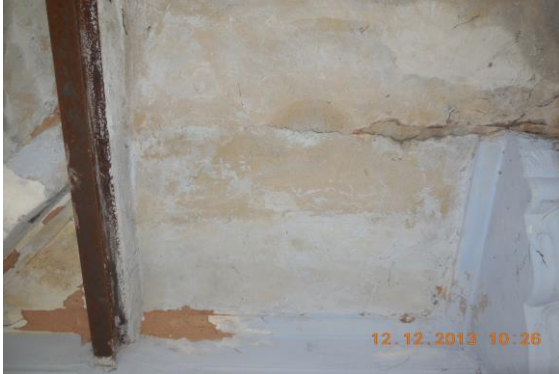
Photo 56

Peeling of Plaster on Roof of Lobby of House No. 651, Ground Floor

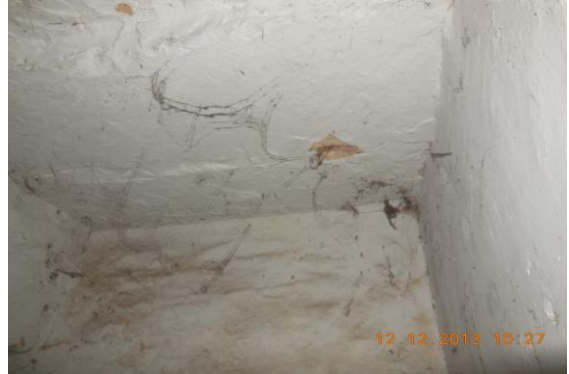
Photo 57

Peeling of Plaster on Roof of Store-1 of House No. 651, Ground Floor

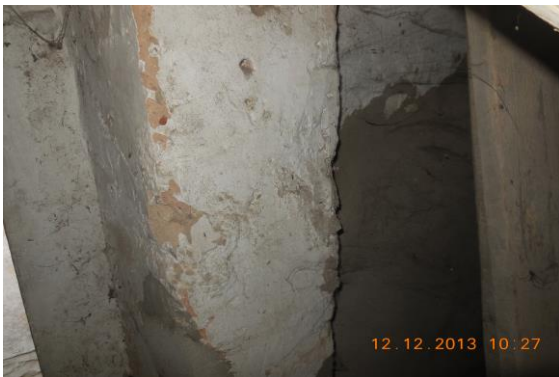
Photo 58

Peeling of Plaster on Wall No. 1 of Store-1 of House No. 651, Ground Floor

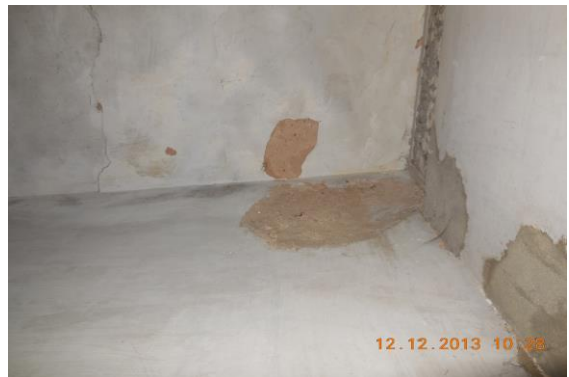
Photo 59

Peeling of Plaster on Wall No. 3 & Roof of Stair Case GF to FF of House No. 651, Ground Floor

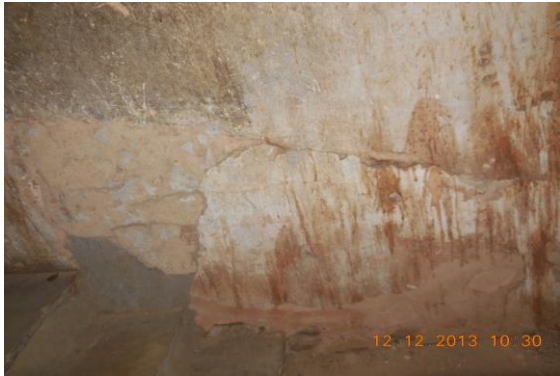
Photo 60

Peeling of Plaster on of Stair Case GF to FF of House No. 651, Ground Floor

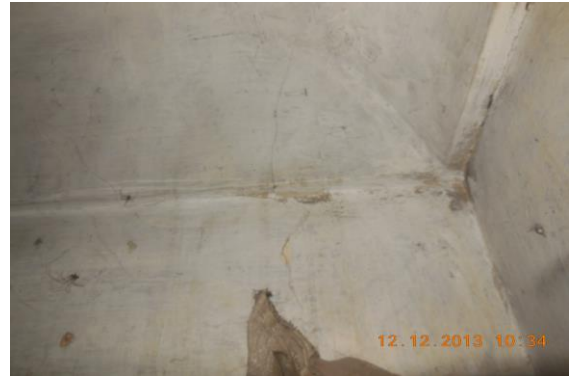
Photo 61

Plaster Crack on Wall No. 4 & Roof of Verandah of Ground Floor

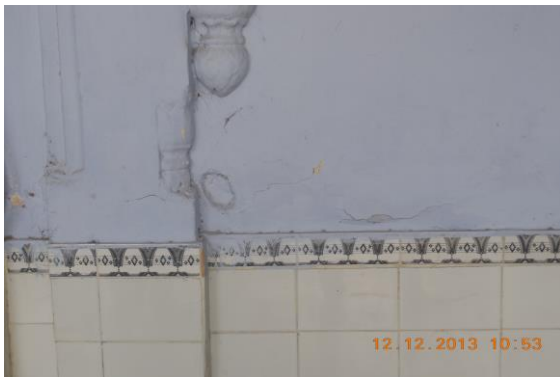
Photo 62

Peeling of Plaster on Wall No. 3 of Verandah of House No. 651, Ground Floor

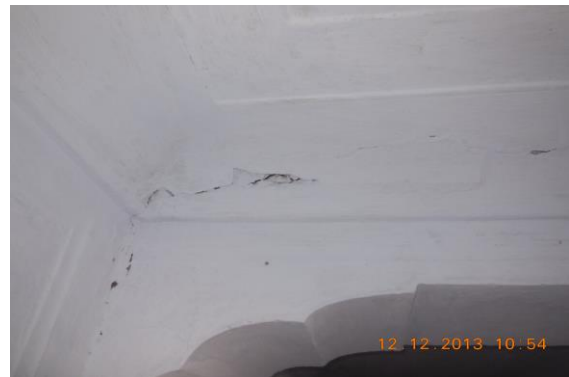
Photo 63

Peeling of Plaster on Roof of Verandah of House No. 651, Ground Floor

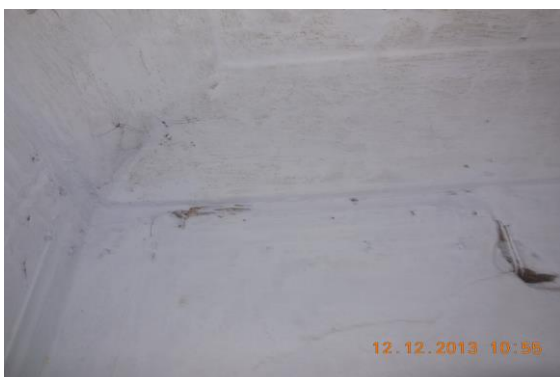
Photo 64

Dampness/Seepage on Wall No. 2 & Roof of Verandah of House No. 651, Ground Floor

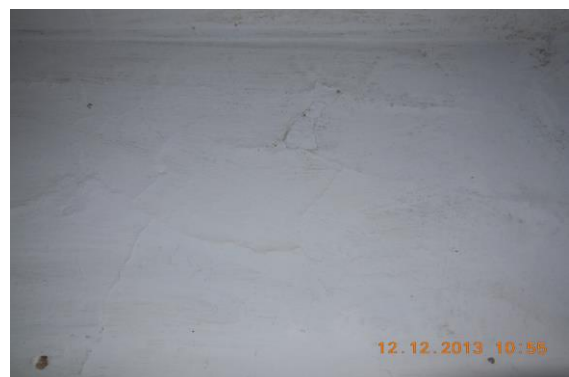
Photo 65

Peeling of Plaster on Wall No. 6 of Verandah of House No. 651, Ground Floor

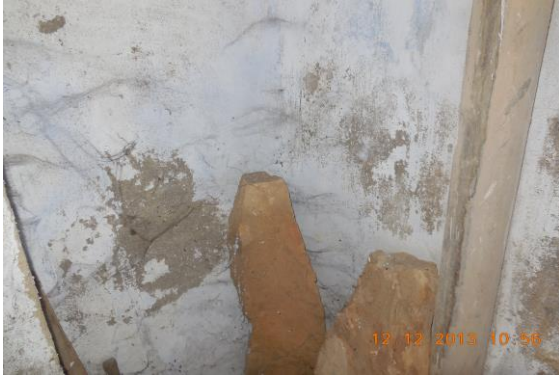
Photo 66

Dampness/Seepage on Wall No. 1 & 4 of Lobby of House No. 651, Ground Floor

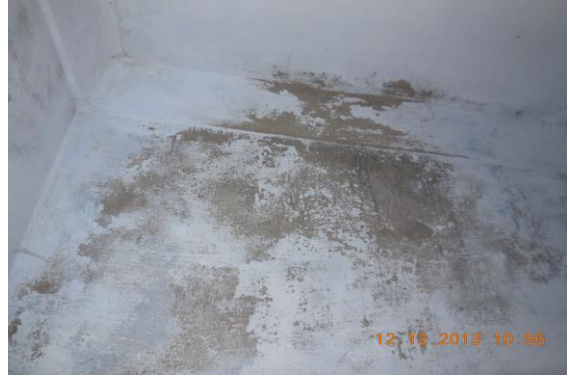
Photo 67

Dampness/Seepage on Wall No. 1 & Roof of Passage of House No. 651, Ground Floor

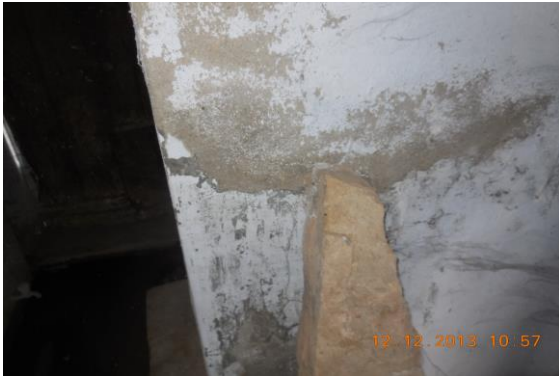
Photo 68

Peeling of Plaster on Wall No. 6 & 7 of Passage of House No. 651, Ground Floor

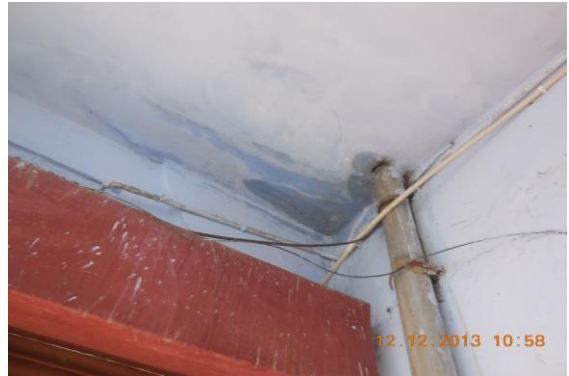
Photo 69

Dampness/Seepage on Outer Wall of Lift of House No. 651, Ground Floor

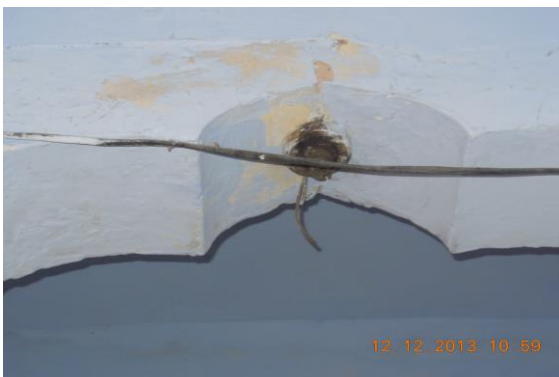
Photo 70

Peeling of Plaster on Wall No. 3 of Lift of House No. 651, Ground Floor

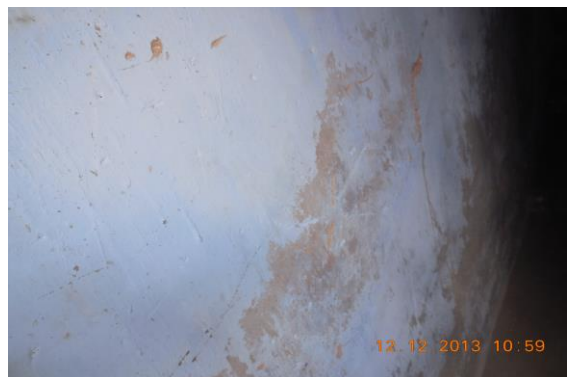
Photo 71

Peeling of Plaster on Wall No. 1 of Stair Case GF to FF of House No. 651, Ground Floor

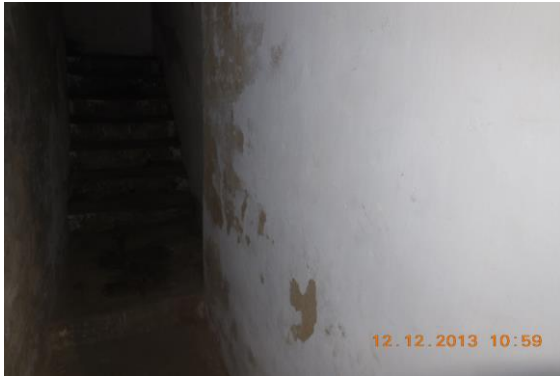
Photo 72

Peeling of Plaster on Wall No. 2 of Stair Case GF to FF of House No. 651, Ground Floor

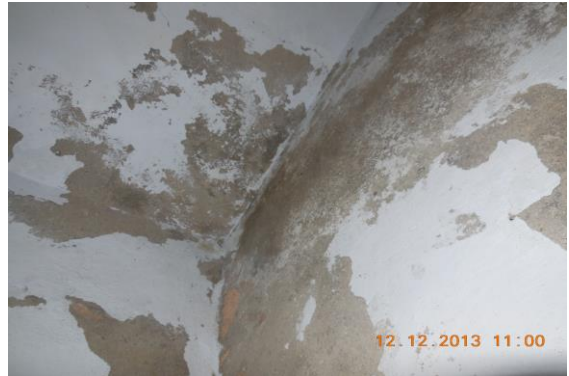
Photo 73

Peeling of Plaster on Wall No. 1 of Stair Case GF to FF of House No. 651, Ground Floor

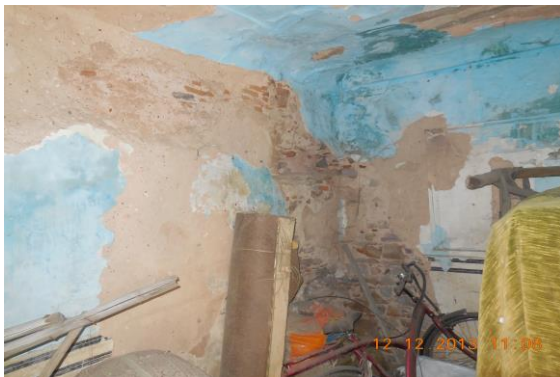
Photo 74

Dampness/Seepage on Wall No. 3, 4 & Roof of Room No. 5 of First Floor

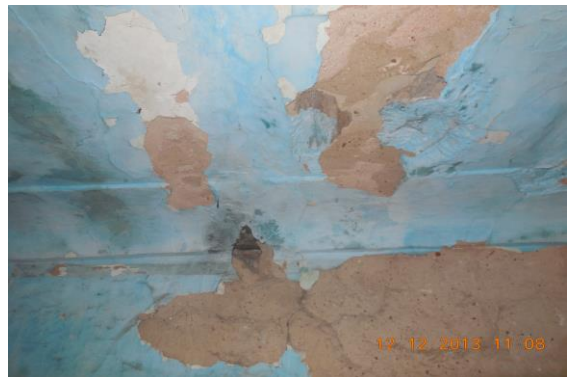
Photo 75

Dampness/Seepage on Wall No. 3, 4 & Roof of Room No. 5 of First Floor

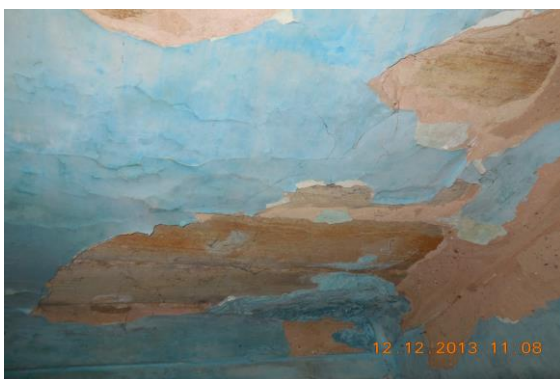
Photo 76

Dampness/Seepage on Wall No. 3, 4 & Roof of Room No. 5 of First Floor

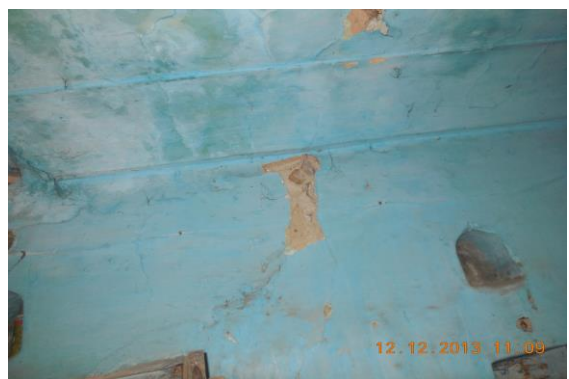
Photo 77

Dampness/Seepage on Wall No. 3, 4 & Roof of Room No. 5 of First Floor

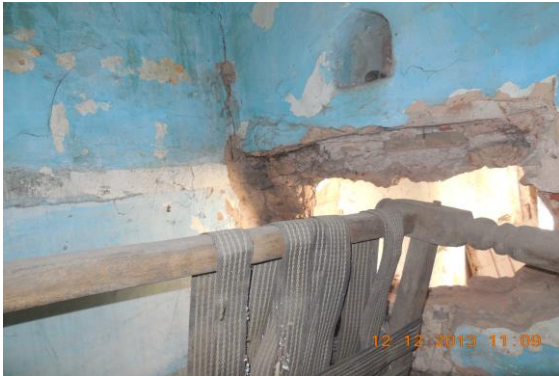
Photo 78

Dampness/Seepage on Wall No. 3, 4 & Roof of Room No. 5 of First Floor

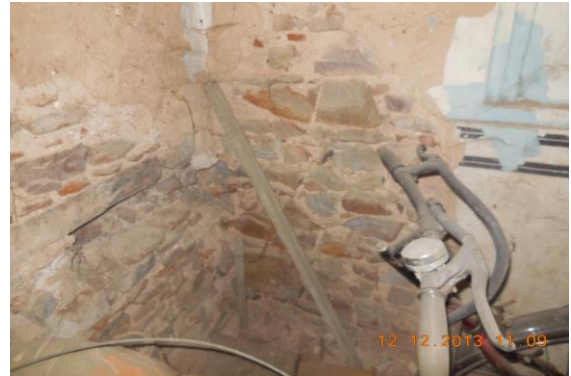
Photo 79

Dampness/Seepage on Wall No. 3, 4 & Roof of Room No. 5 of First Floor

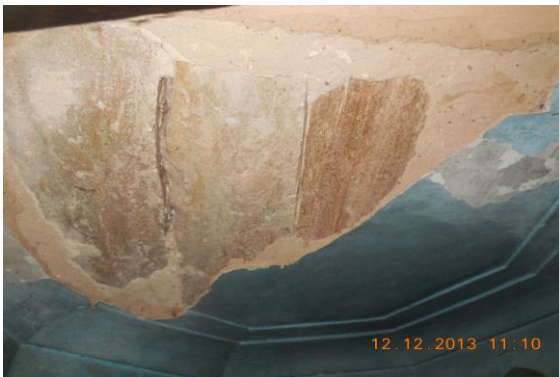
Photo 80

Dampness/Seepage on Roof of Tome 3 of House No. 651, First Floor

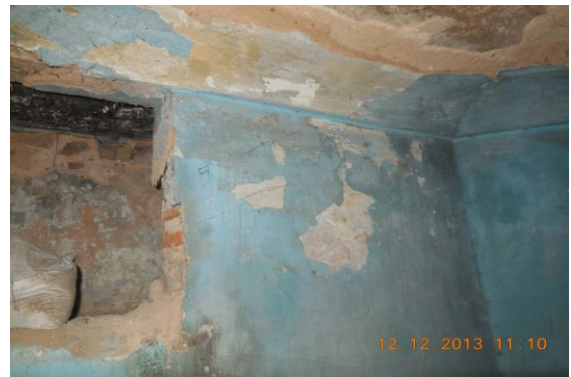
Photo 81

Peeling of Plaster on Wall No. 1 of Tome 3 of House No. 651, First Floor

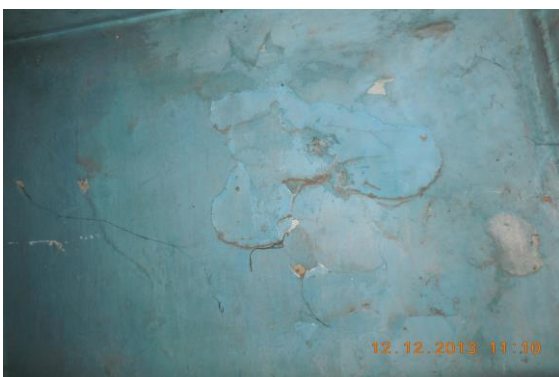
Photo 82

Peeling of Plaster on Wall No. 2 of Tome 3 of House No. 651, First Floor

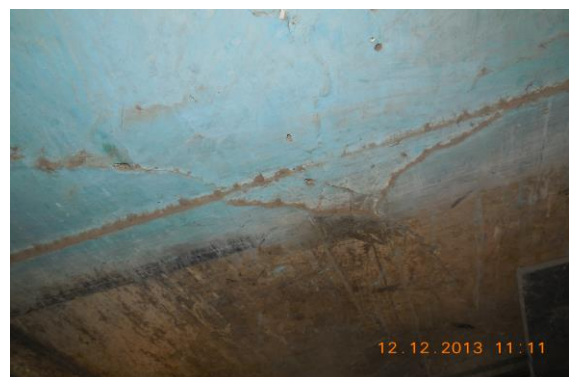
Photo 83

Dampness/Seepage on Wall No. 2 of Tome 3 of House No. 651, First Floor

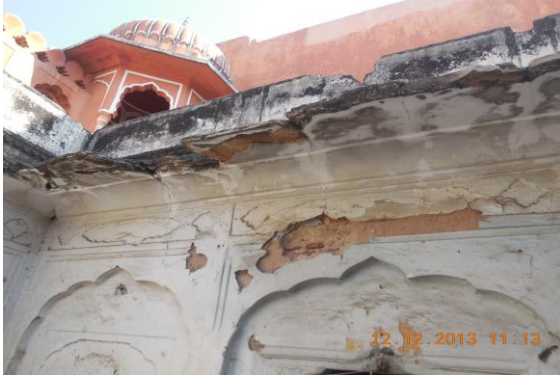
Photo 84

Dampness/Seepage on Wall No. 4 of Sunshade Open Area 2 of House No. 651, First Floor

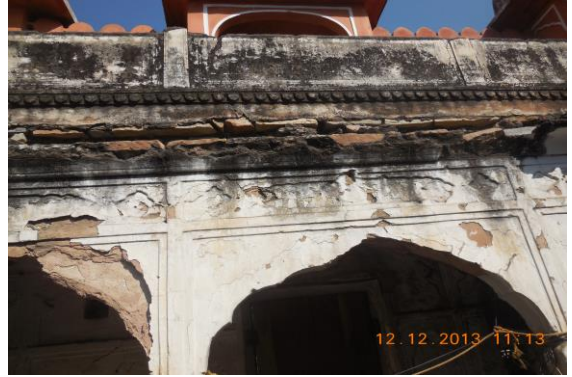
Photo 85

Dampness/Seepage on Wall No. 1 of Open Sky-2 of House No. 651, First Floor

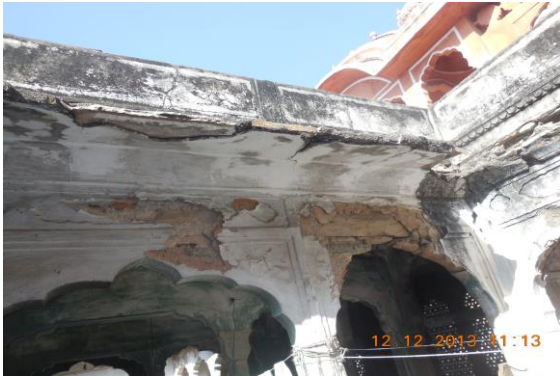
Photo 86

Dampness/Seepage on Wall No. 3 of Open Sky-2 of House No. 651, First Floor

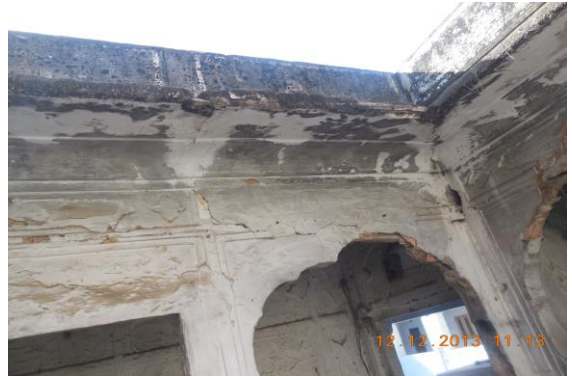
Photo 87

Dampness/Seepage on Wall No. 2 of Open Sky-2 of House No. 651, First Floor

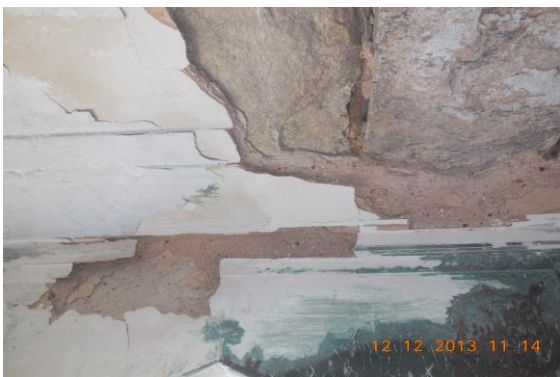
Photo 88

Dampness/Seepage on All Walls & Roof of Lobby 2 of House No. 651, First Floor

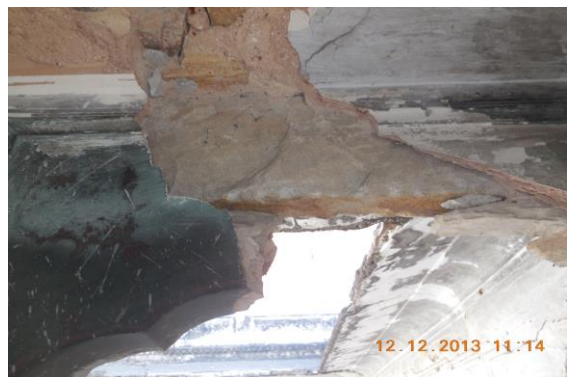
Photo 89

Dampness/Seepage on All Walls & Roof of Lobby 2 of House No. 651, First Floor
