Pre Building Condition Survey Report

Name and Address of Structure :	Choti Chopar to Badi Chopar (Down Line)
---------------------------------	---

Name of the Project	Contract JMRC-UG1B “Design and Construction of Tunnel between Chandpole and Badi Chouper and reverse line by Shield TBM, Underground Metro Stations at Choti Chouper and Badi Chouper by Cut and Cover Methods on East West Corridor of Jaipur Metro Rail Corporation Limited .”	
Owner :

Pre Building Condition Survey Report Choti Chopar to Badi Chopar (Down Line)

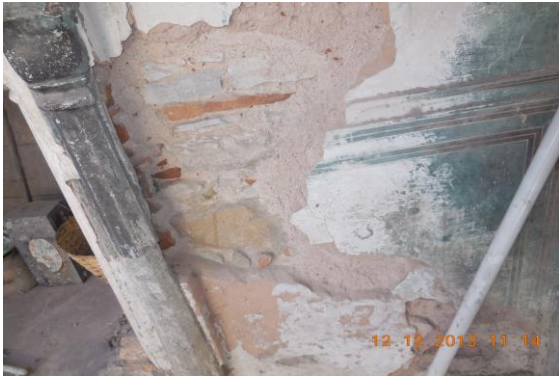
Photo 90

Dampness/Seepage on All Walls & Roof of Lobby 2 of House No. 651, First Floor

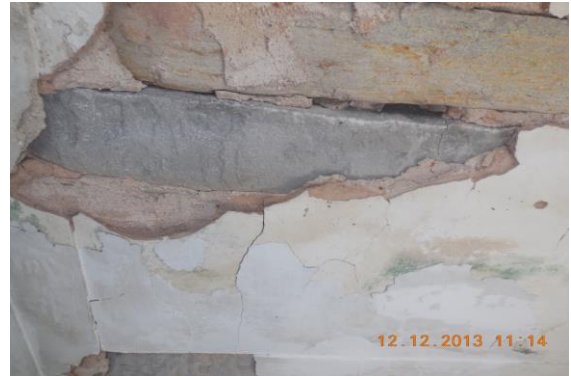
Photo 91

Dampness/Seepage on All Walls & Roof of Lobby 2 of House No. 651, First Floor

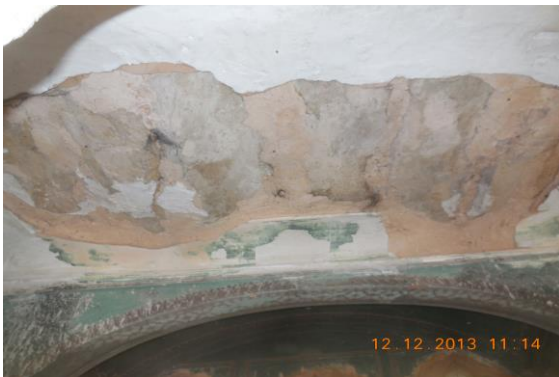
Photo 92

Dampness/Seepage on All Walls & Roof of Lobby 2 of House No. 651, First Floor

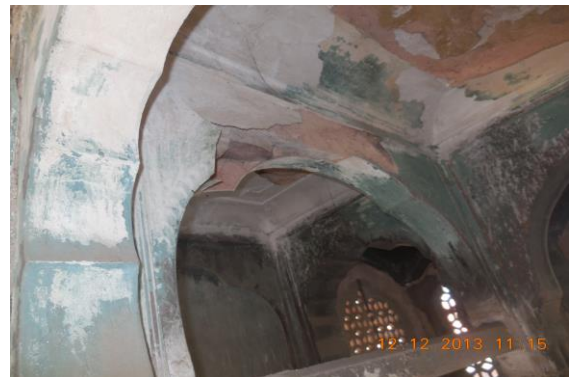
Photo 93

Dampness/Seepage on All Walls & Roof of Lobby 2 of House No. 651, First Floor

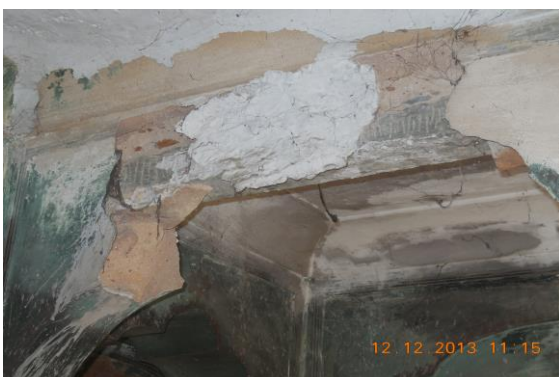
Photo 94

Dampness/Seepage on All Walls & Roof of Lobby 2 of House No. 651, First Floor

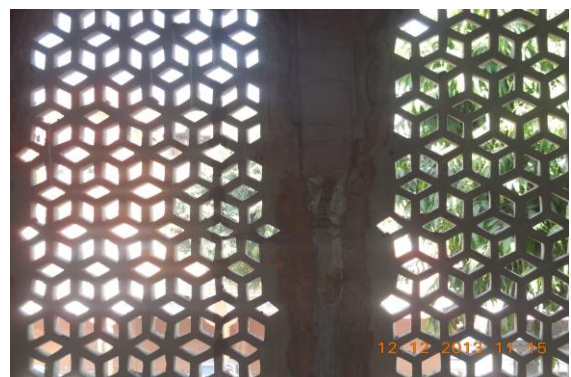
Photo 95

Dampness/Seepage on All Walls & Roof of Lobby 2 of House No. 651, First Floor

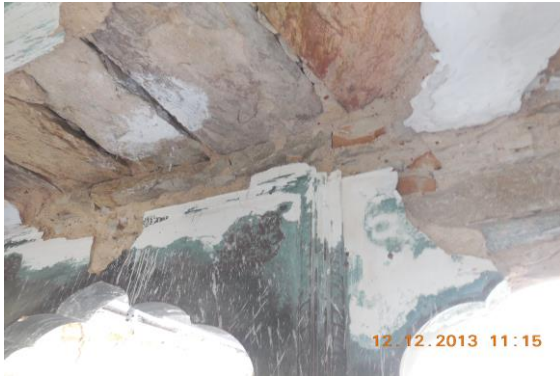
Photo 96

Dampness/Seepage on All Walls & Roof of Lobby 2 of House No. 651, First Floor

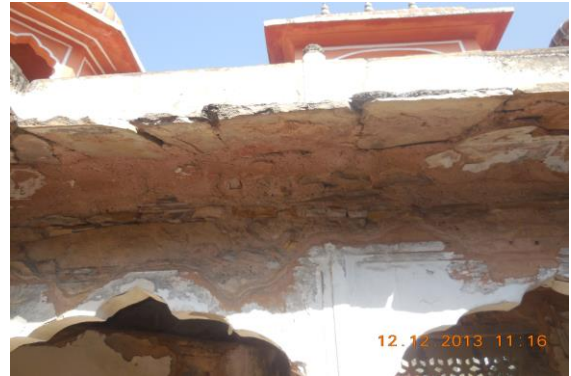
Photo 97

Dampness/Seepage on All Walls of Open Area 1 of House No. 651, First Floor

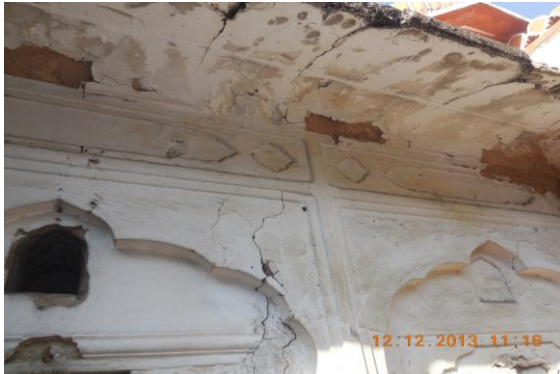
Photo 98

Dampness/Seepage on All Walls of Open Area 1 of House No. 651, First Floor

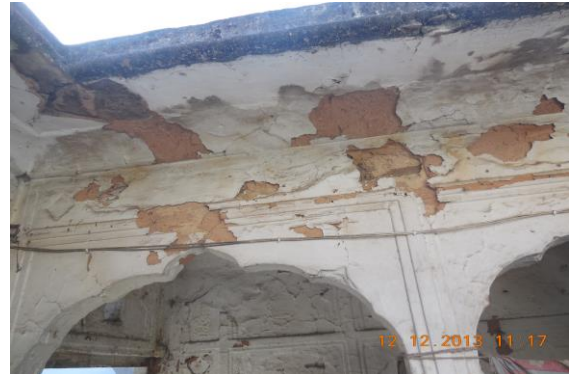
Photo 99

Dampness/Seepage on All Walls of Open Area 1 of House No. 651, First Floor

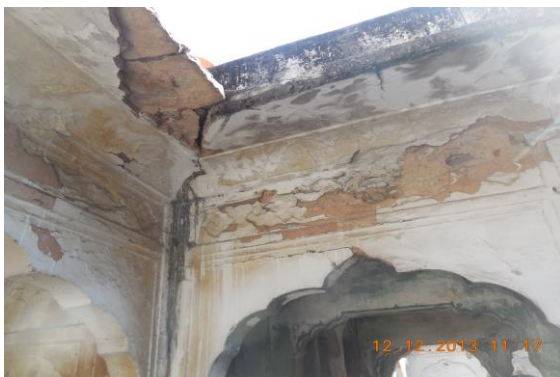
Photo 100

Dampness/Seepage on All Walls of Open Area 1 of House No. 651, First Floor

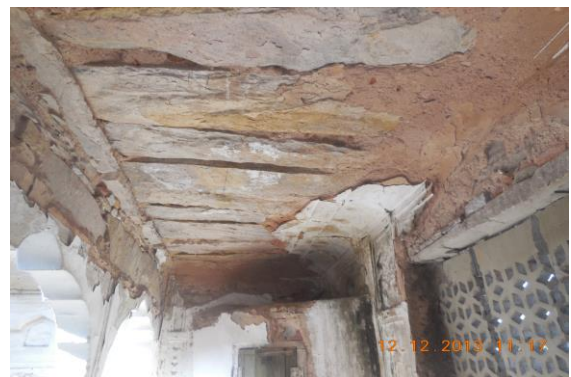
Photo 101

Dampness/Seepage on All Walls of Open Area 1 of House No. 651, First Floor

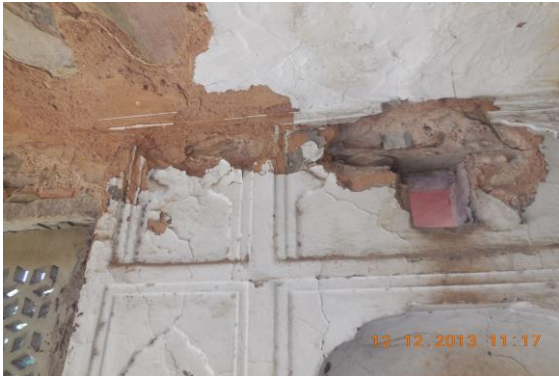
Photo 102

Dampness/Seepage on All Walls of Open Area 1 of House No. 651, First Floor

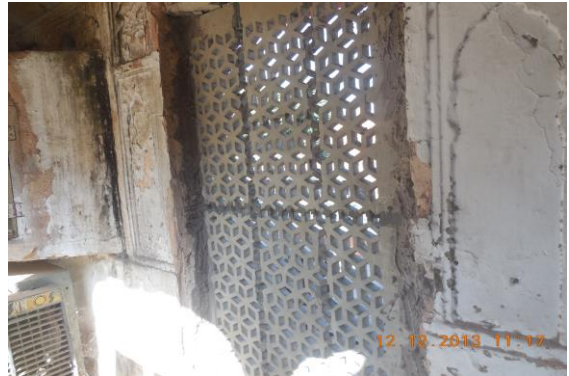
Photo 103

Dampness/Seepage on All Walls of Open Area 1 of House No. 651, First Floor

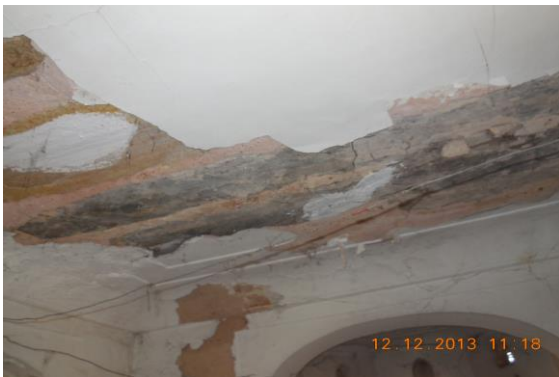
Photo 104

Dampness/Seepage on All Walls & Roof of Room No. 6 of House No. 651, First Floor

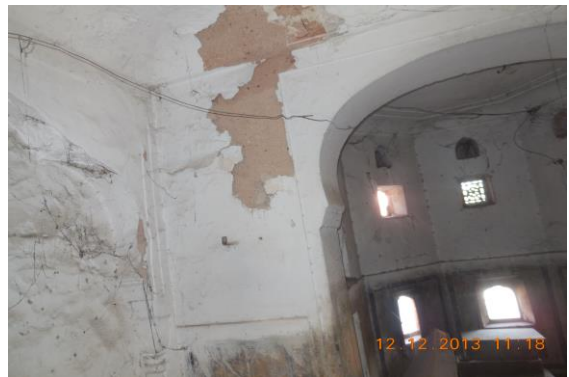
Photo 105

Dampness/Seepage on All Walls & Roof of Room No. 6 of House No. 651, First Floor

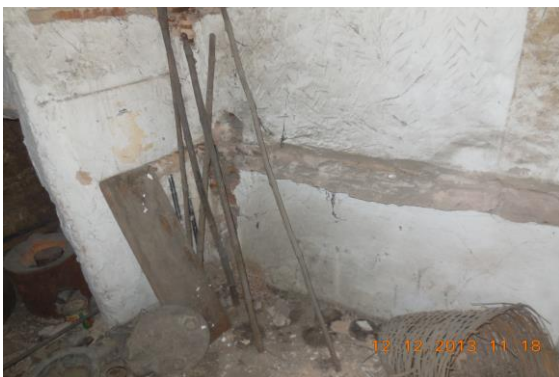
Photo 106

Dampness/Seepage on All Walls & Roof of Room No. 6 of House No. 651, First Floor

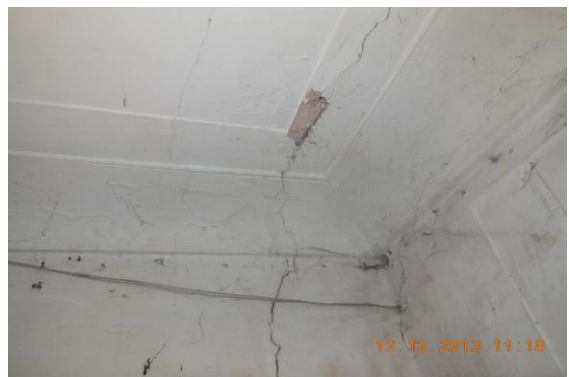
Photo 107

Dampness/Seepage on All Walls & Roof of Room No. 6 of House No. 651, First Floor

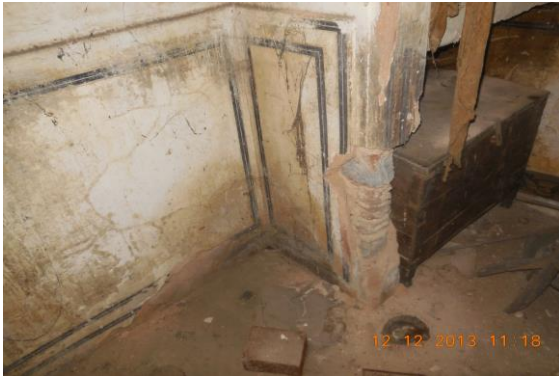
Photo 108

Dampness/Seepage on All Walls & Roof of Room No. 6 of House No. 651, First Floor

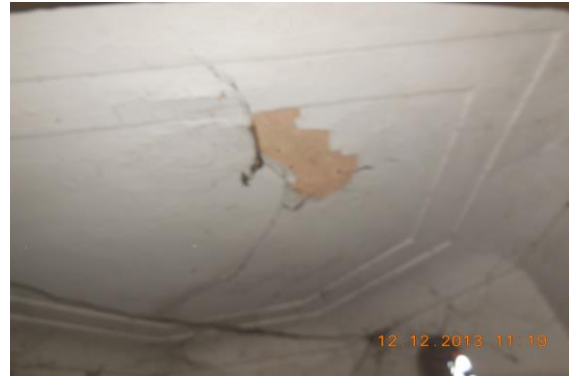
Photo 109

Peeling of Plaster on Roof of Tomb 4 of House No. 651, First Floor

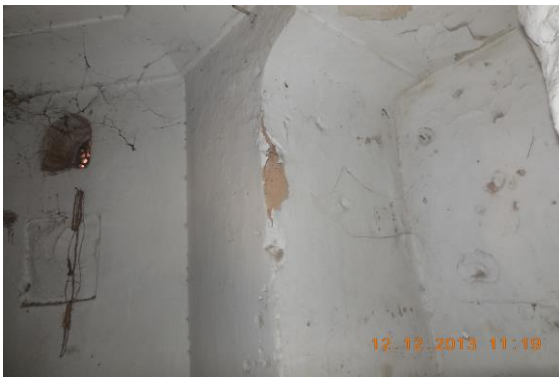
Photo 110

Peeling of Plaster on Wall No. 2 of Tomb 4 of House No. 651, First Floor

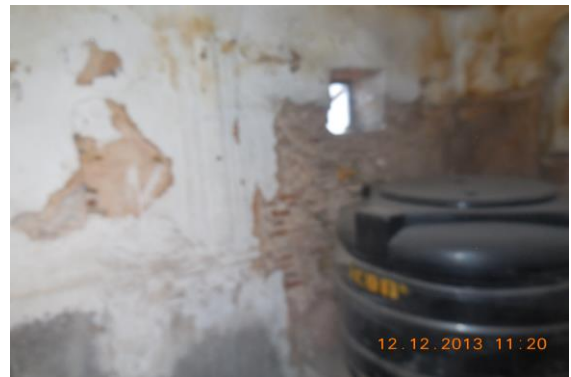
Photo 111

Dampness/Seepage on Wall No. 3 of Passage of House No. 651, First Floor

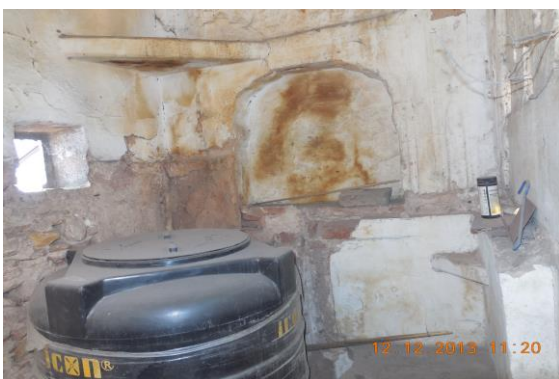
Photo 112

Dampness/Seepage on Wall No. 1 of Passage of House No. 651, First Floor

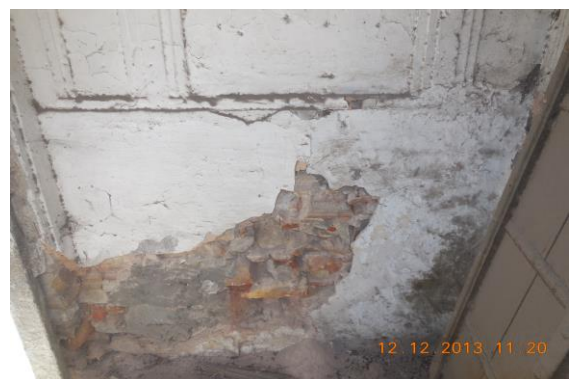
Photo 113

Dampness/Seepage on Roof of Passage of House No. 651, First Floor

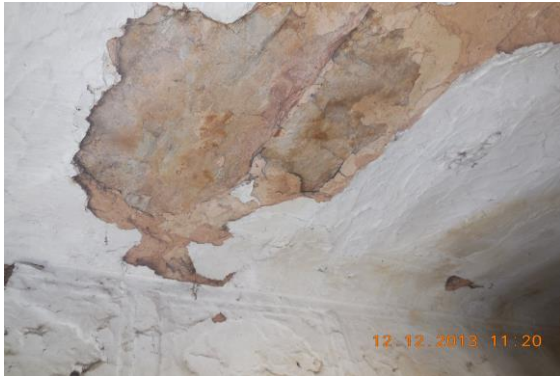
Photo 114

Dampness/Seepage on Wall No. 4 of Passage of House No. 651, First Floor

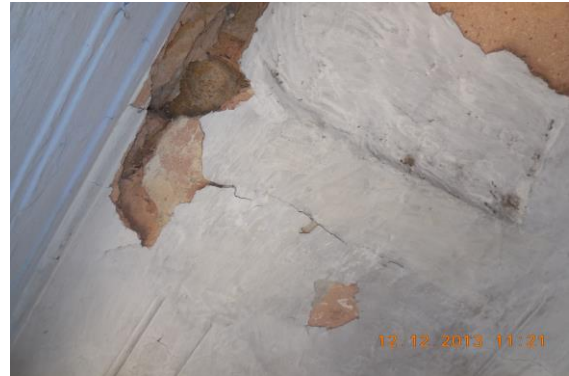
Photo 115

Dampness/Seepage on All Walls & Roof of Passage of House No. 651, First Floor

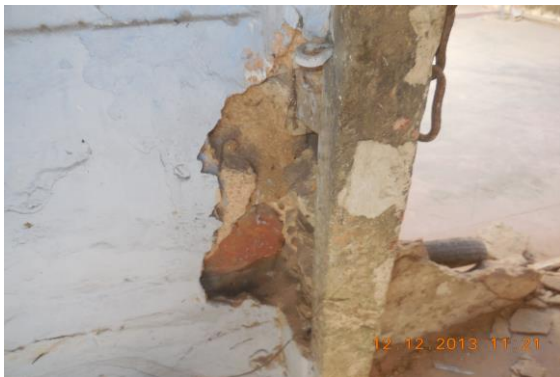
Photo 116

Dampness/Seepage on All Walls & Roof of Passage of House No. 651, First Floor

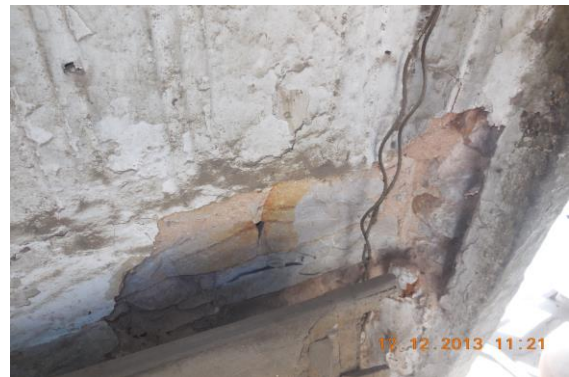
Photo 117

Dampness/Seepage on All Walls & Roof of Passage of House No. 651, First Floor

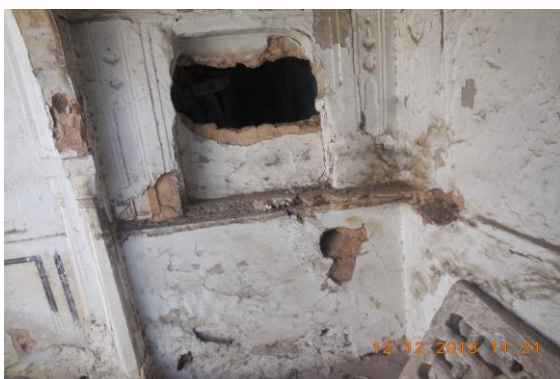
Photo 118

Dampness/Seepage on All Walls & Roof of Passage of House No. 651, First Floor

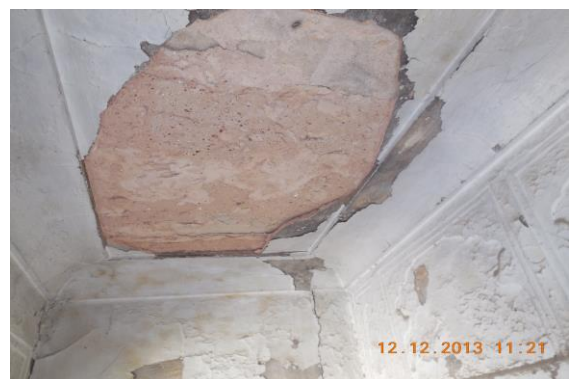
Photo 119

Dampness/Seepage on All Walls & Roof of Passage of House No. 651, First Floor

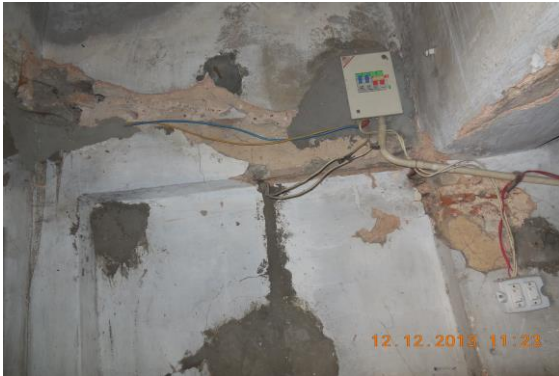
Photo 120

Dampness/Seepage on Wall No. 2 of Stair Case of House No. 651, First Floor

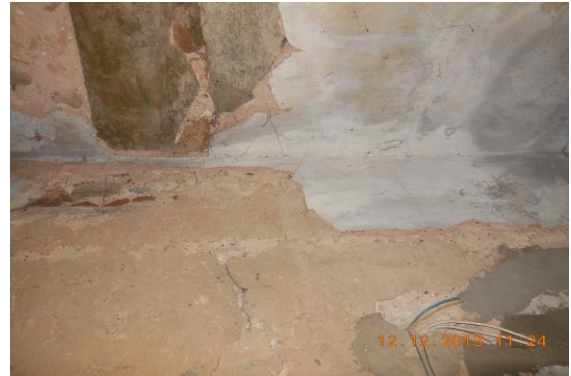
Photo 121

Dampness/Seepage on Wall No. 4 & Roof of Stair Case of House No. 651, First Floor

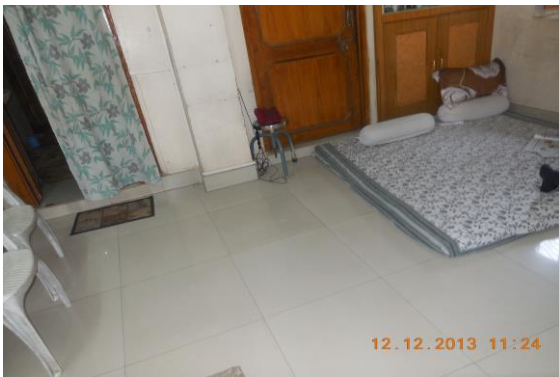
Photo 122

Damaged Portion on Floor of Hall No. 2 of House No. 651, First Floor

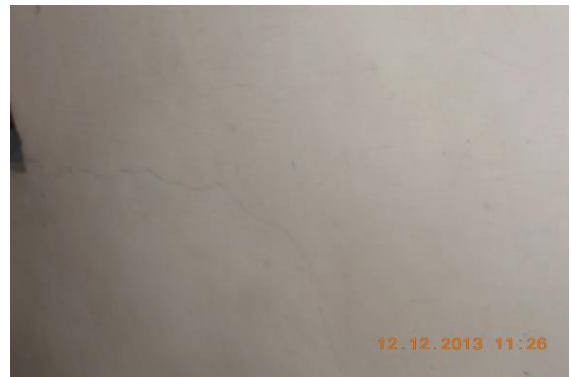
Photo 123

Peeling of Plaster on Wall No. 1 of Hall No. 2 of House No. 651, First Floor

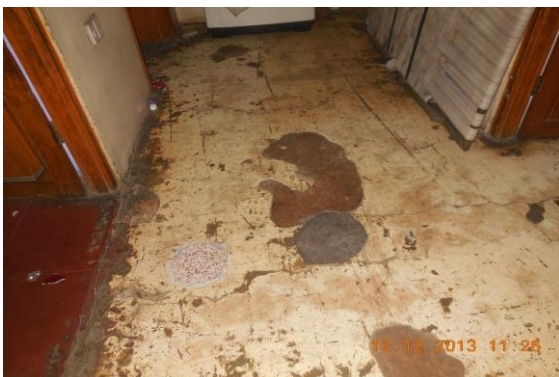
Photo 124

Peeling of Plaster on Floor of Lobby of House No. 651, First Floor

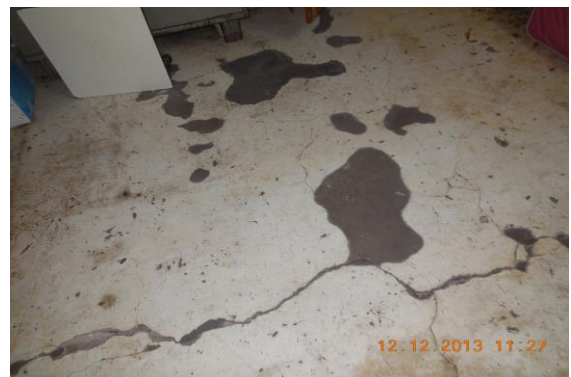
Photo 125

Peeling of Plaster on Room No. 8 of House No. 651, First Floor

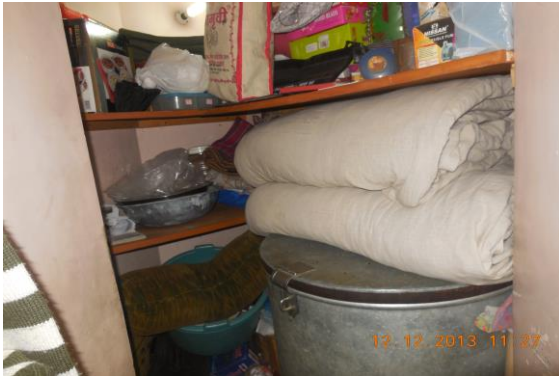
Photo 126

Damaged Portion on Tomb 2 of House No. 651, First Floor

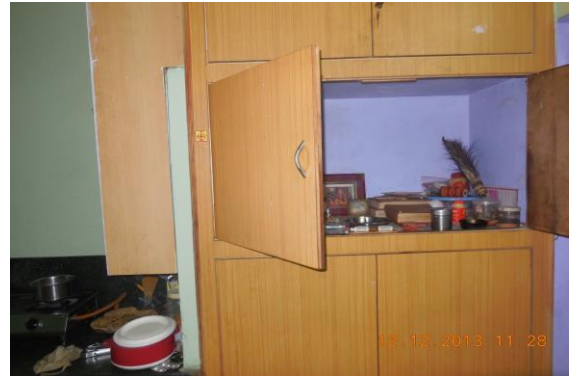
Photo 127

Damaged Portion on Wall No. 4 of Kitchen of House No. 651, First Floor

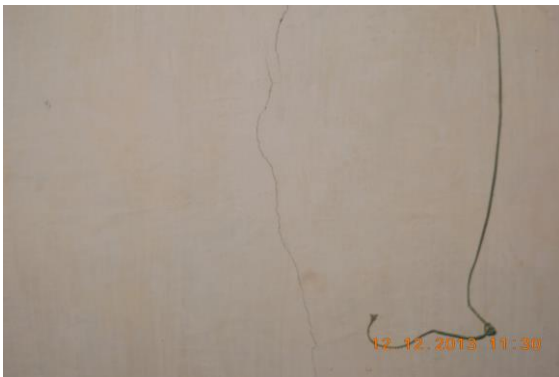
Photo 128

Plaster Crack on Wall No. 1 of House No. 651, First Floor

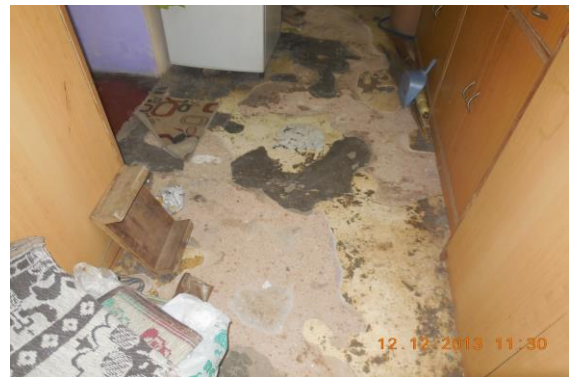
Photo 129

Peeling of Plaster on Wall No. Floor of House No. 651, First Floor

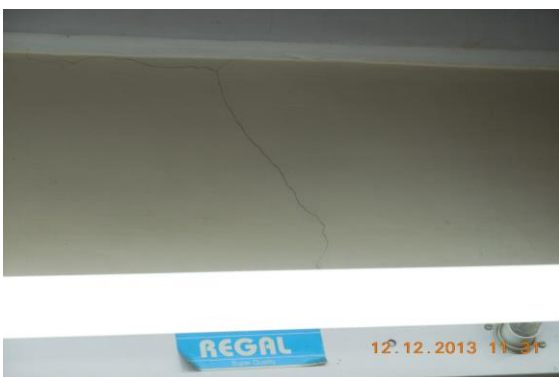
Photo 130

Plaster Crack on Wall No. 4 of Lobby 3 of House No. 651, First Floor

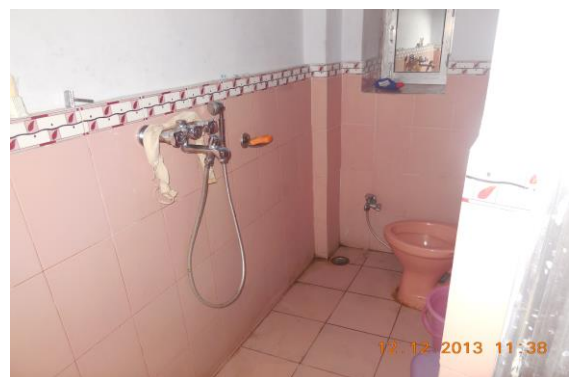
Photo 131

Damaged Portion on Toilet No. 1 of House No. 651, First Floor

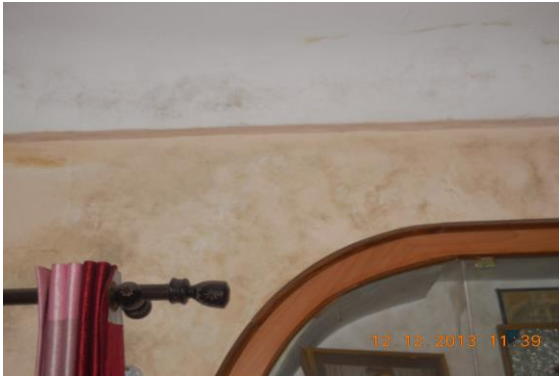
Photo 132

Dampness/Seepage on Wall No. 1 of Hall No. 1 of House No. 651, First Floor

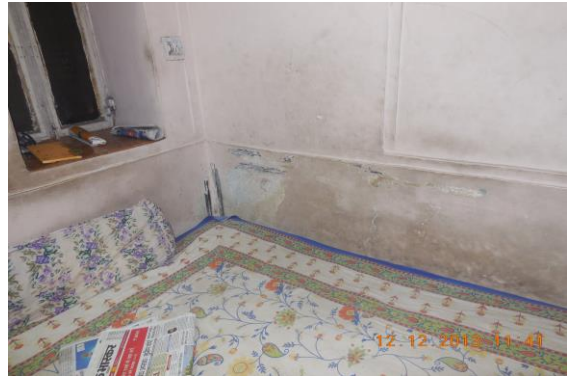
Photo 133

Peeling of Plaster on Wall No. 2 of Room No. 3 of House No. 651, First Floor

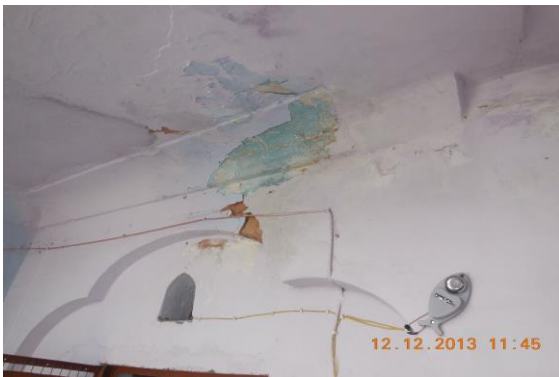
Photo 134

Dampness/Seepage on Wall No. 3 of Varanda of House No. 651, First Floor

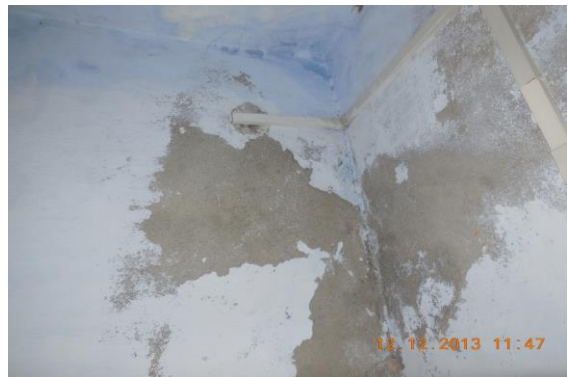
Photo 135

Dampness/Seepage on Wall No. 2 & 3 of Stair Case of House No. 651, Second Floor

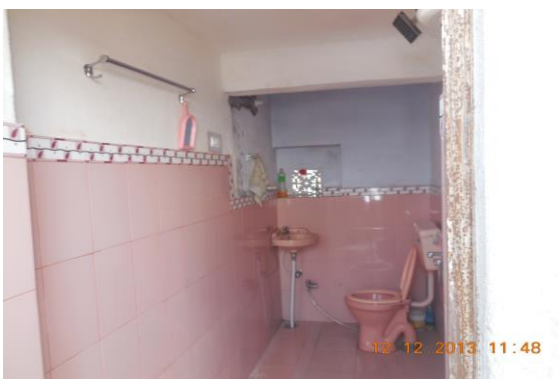
Photo 136

Damaged Portion on Wall No. 1, 2, 3 & 4 of Bathroom No. of House No. 651, Second Floor

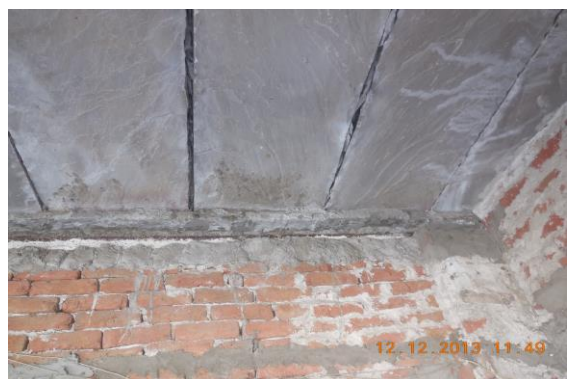
Photo 137

Damaged Portion of Varanda of House No. 651, Second Floor

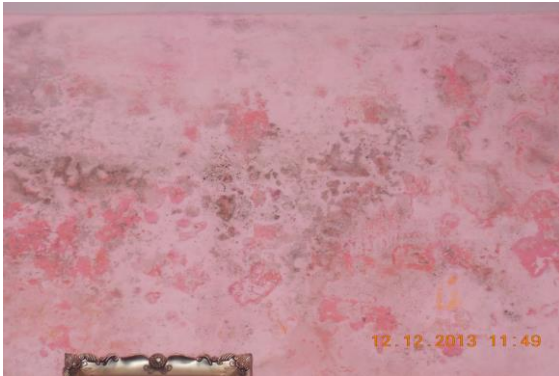
Photo 138

Dampness/Seepage on Wall No. 1 of Room No. 1 of House No. 651, Second Floor

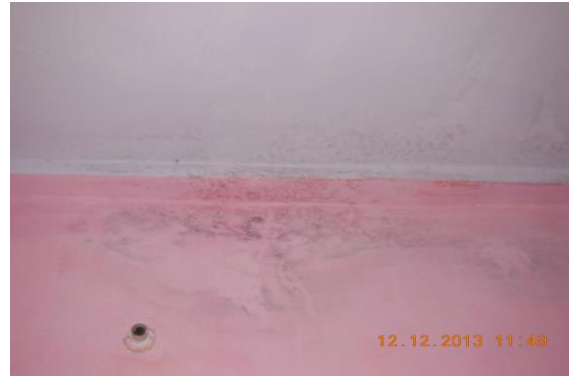
Photo 139

Dampness/Seepage on Wall No. 3 & Roof of Room No. 1 of House No. 651, Second Floor

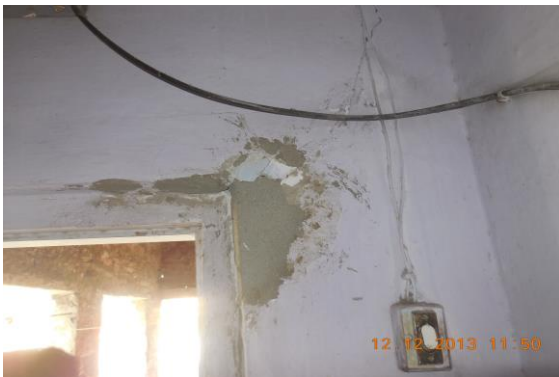
Photo 140

Peeling of Plaster on Wall No. 3 of Hall No. 1 of House No. 651, Second Floor

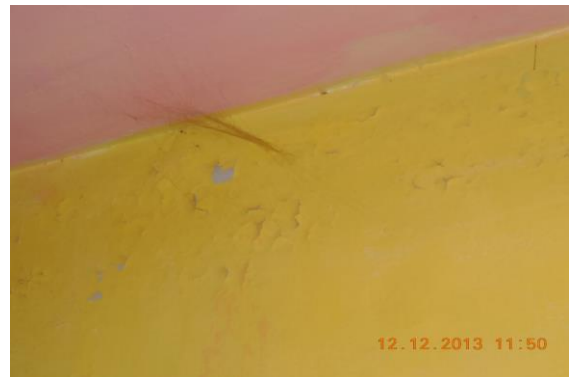
Photo 141

Peeling of Plaster on Wall No. 1 & 2 of Kitchen of House No. 651, Second Floor

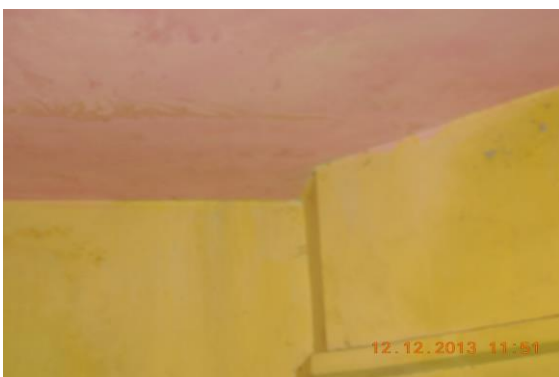
Photo 142

Peeling of Plaster on Wall No. 4 & Roof of Kitchen of House No. 651, Second Floor

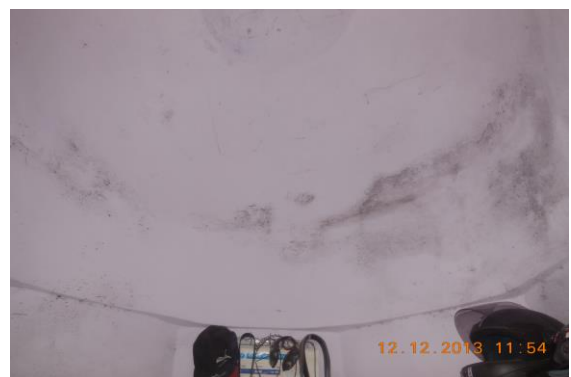
Photo 143

Dampness/Seepage on Wall No. All wall of Dressing Room of House No. 651, Second Floor

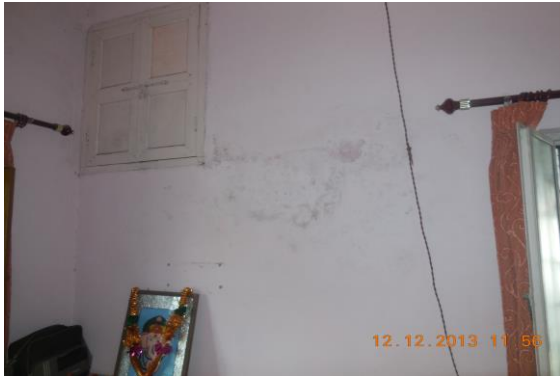
Photo 144

Dampness/Seepage on Wall No. 2 of Room No. 3 of House No. 651, Second Floor

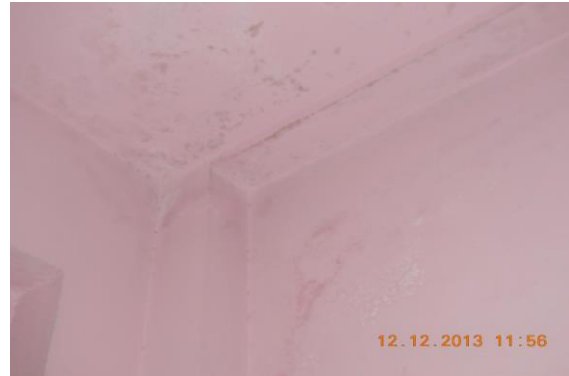
Photo 145

Dampness/Seepage on Wall No. 3 & Roof of Room No. 3 of House No. 651, Second Floor

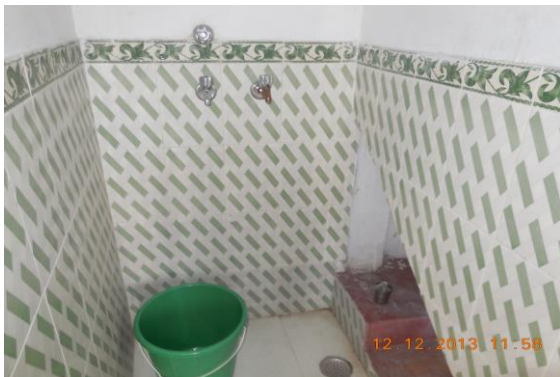
Photo 146

Damaged Portion on All wall of Bathroom No. of House No. 651, Second Floor

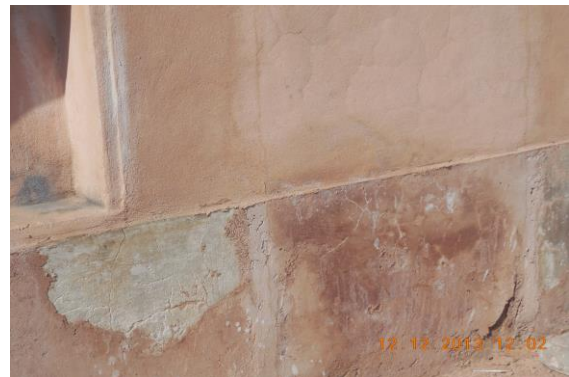
Photo 147

Peeling of Plaster on Wall No. 4 of Open Area of House No. 651, Second Floor

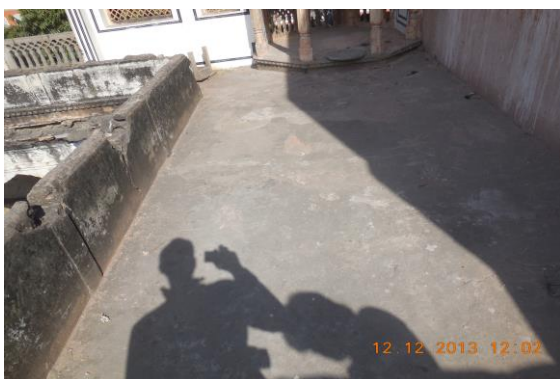
Photo 148

Peeling of Plaster on Floor of Open Area of House No. 651, Second Floor

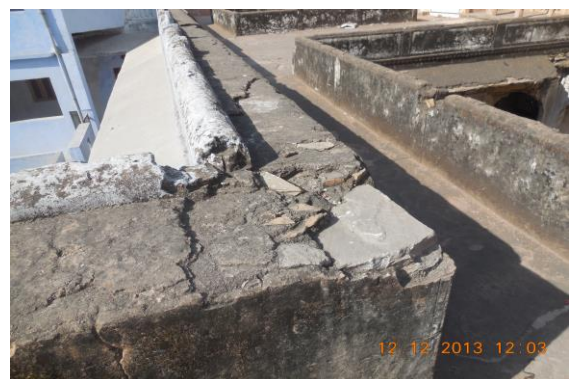
Photo 149

Dampness/Seepage on Parapet Wall 1 of House No. 651, Second Floor

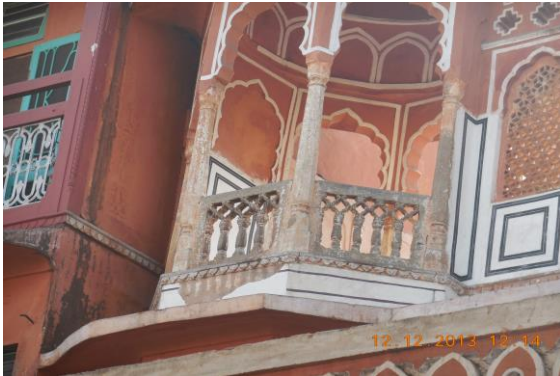
Photo 150
Peeling of Plaster on Front of Building portion of House No. 651,
Second Floor

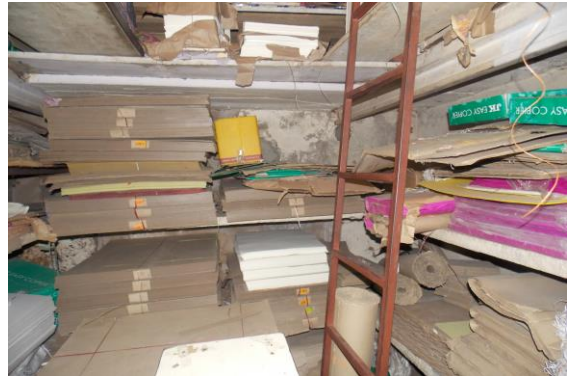
Photo 151
Dampness/Seepage on Wall No. 4 of Shop No.240 of Ground Floor

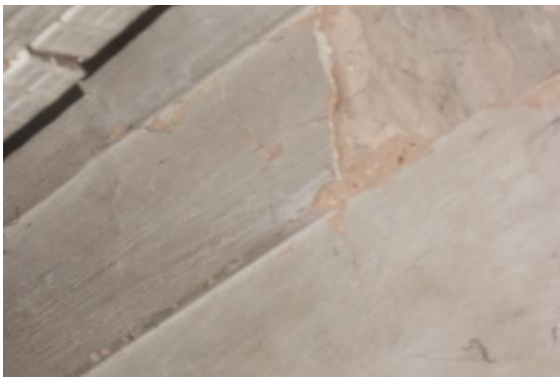
Photo 152
Damaged Portion on Roof of Shop No.239 B of Ground Floor

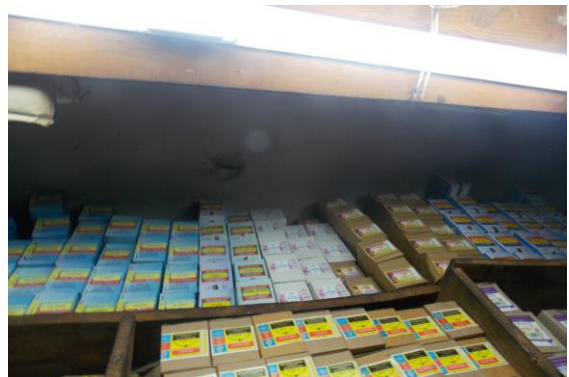
Photo 153
Peeling of Plaster on Roof of Shop No.239 A of Ground Floor

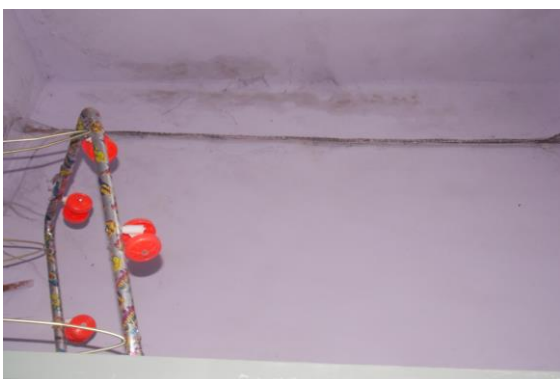
Photo 154
Dampness/Seepage on Wall No. 1 of Shop No.238 of Ground Floor

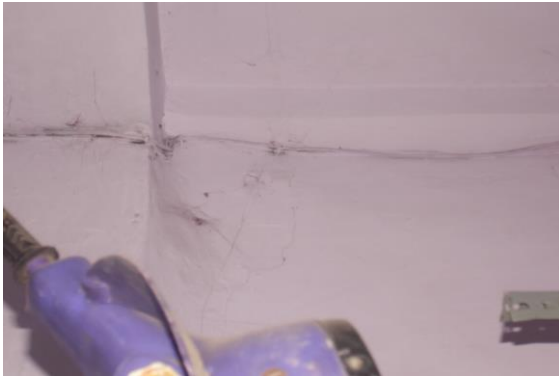
Photo 156
Plaster Crack on Wall No. 2 of Shop No.238 of Ground Floor

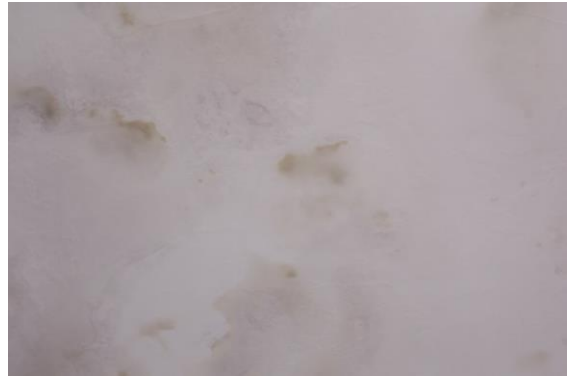
Photo 157
Dampness/Seepage on Roof of Shop No.238 of Ground Floor

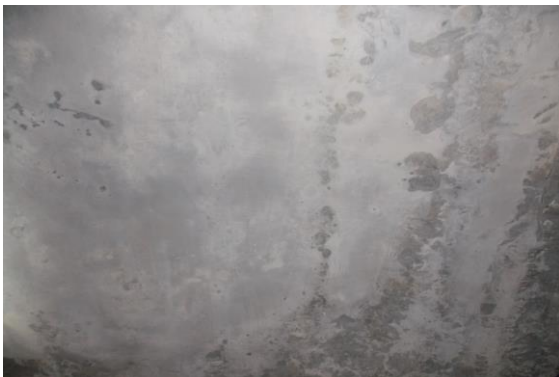
Photo 158
Dampness/Seepage on Roof of Varanda of Shop No.238 of Ground Floor

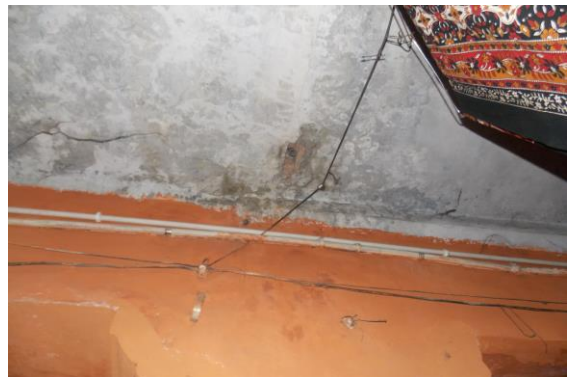
Photo 159
Damaged Portion on Roof of Varanda of Shop No.238 of Ground Floor

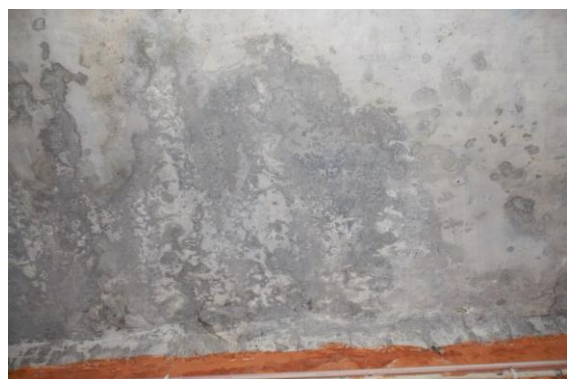
Photo 161
Dampness/Seepage on Roof of Varanda of Shop No.235 of Ground Floor

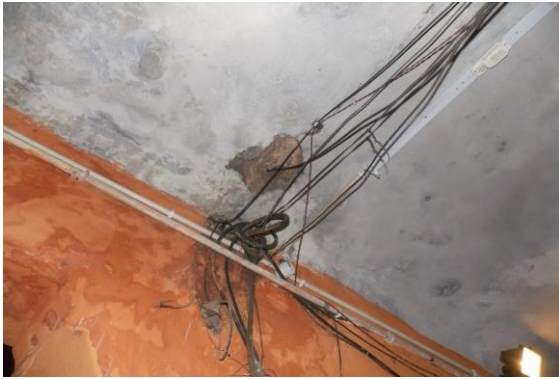
Photo 162

Damaged Portion on Roof of Varanda of Shop No.235 of Ground Floor

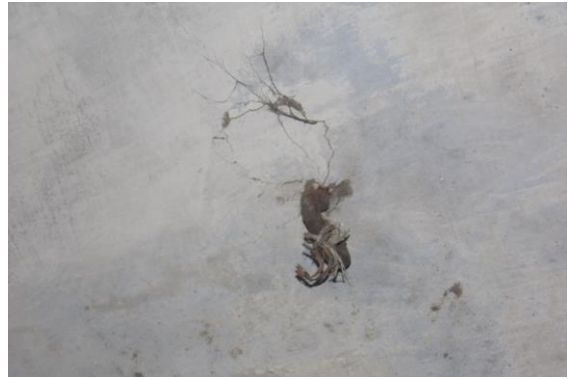
Photo 163

Peeling of Plaster on Roof of Varanda of Shop No.235 of Ground Floor

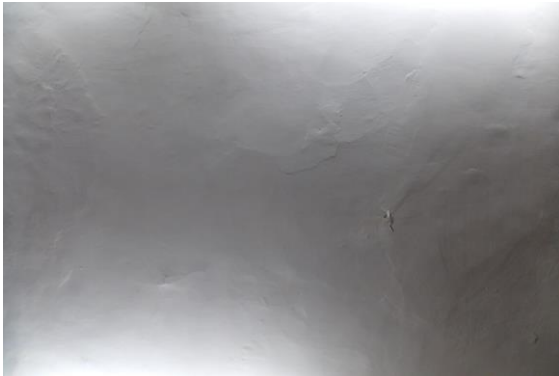
Photo 164

Plaster Crack on Roof of Part A of Shop No.236 of Ground Floor

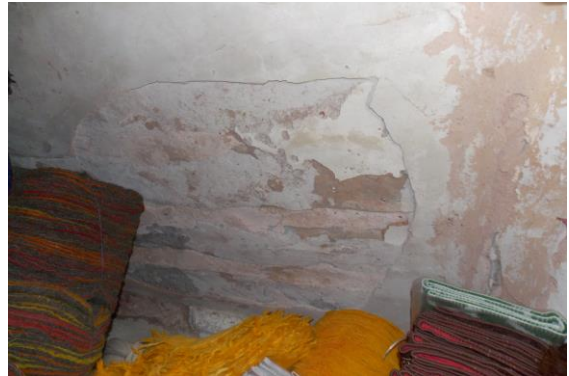
Photo 165

Damaged Portion on Roof of Part B of Shop No.236 of Ground Floor

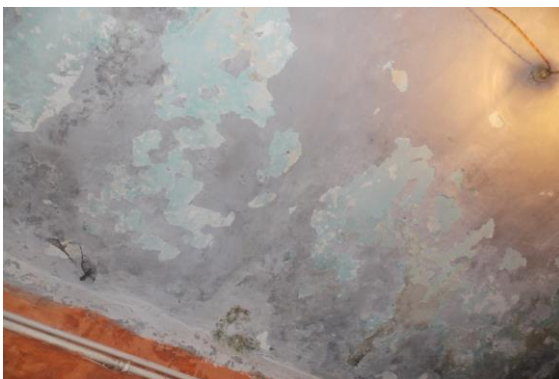
Photo 166

Dampness/Seepage on Roof of Varanda of Shop No.236 of Ground Floor

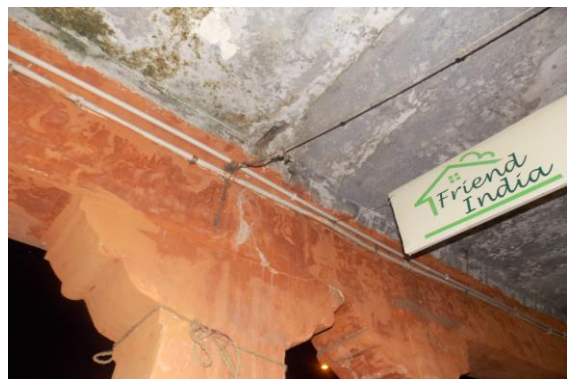
Photo 167

Damaged Portion on Roof of Varanda of Shop No.236 of Ground Floor

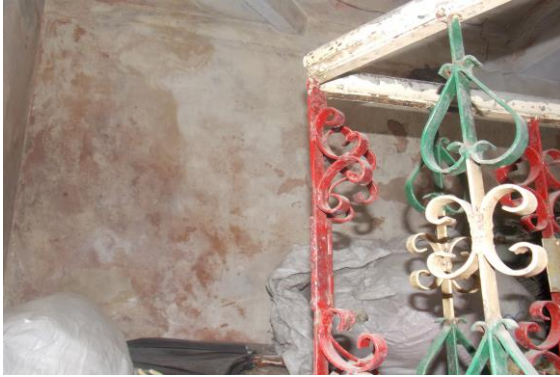
Photo 168

Peeling of Plaster on Roof of Shop No.237 of Upper Ground Floor

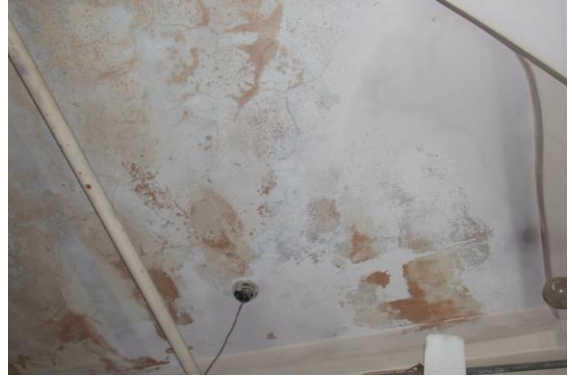
Photo 169

Peeling of Plaster on Roof of Shop No.237 of Upper Ground Floor

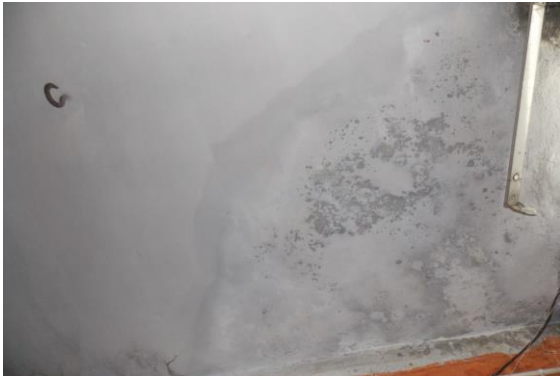
Photo 170

Dampness/Seepage on Roof of Varanda of Shop No 237 of Ground Floor

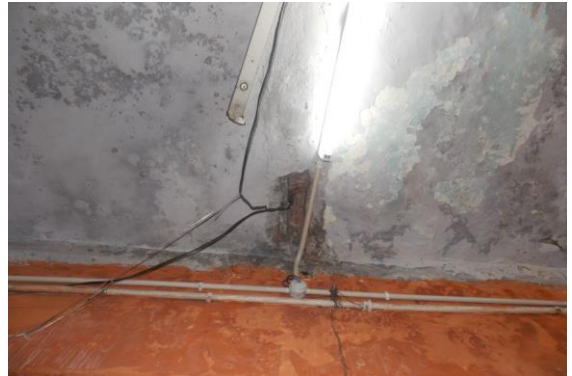
Photo 171

Damaged Portion on Roof of Varanda of Shop No 237 of Ground Floor

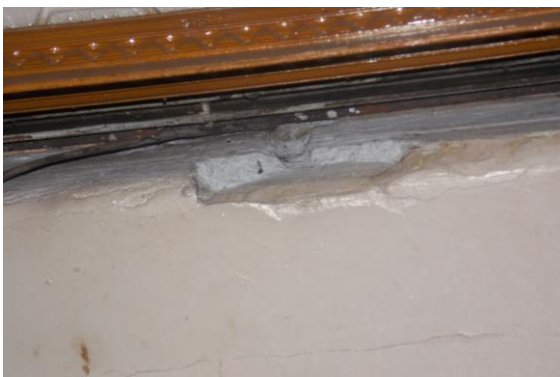
Photo 172

Peeling of Plaster on Wall No. 3 of Varanda of Shop No 237 of Ground Floor

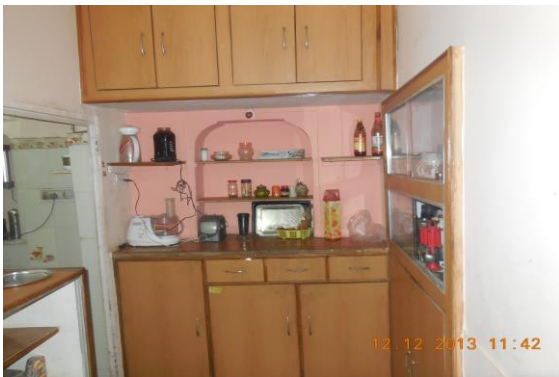
Photo 187

Wall No. 3 of Room No. 4 of House No. 651, First Floor Covered with Almira

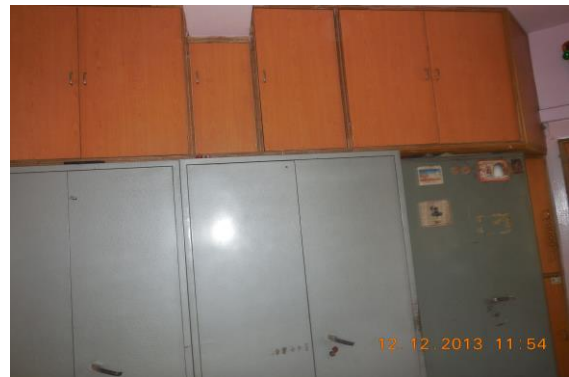
Photo 188

Wall No. 4 of Lobby 1 of House No. 651, First Floor Covered with Almira

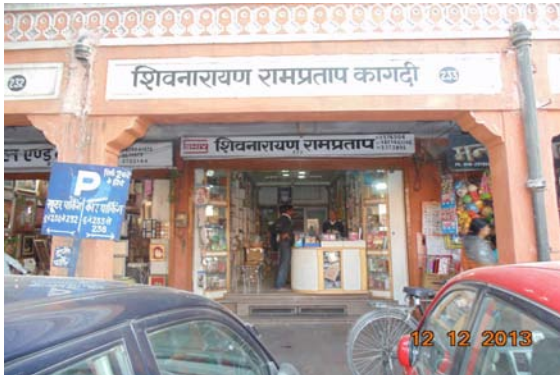
Photo 1
View of Shop No.233

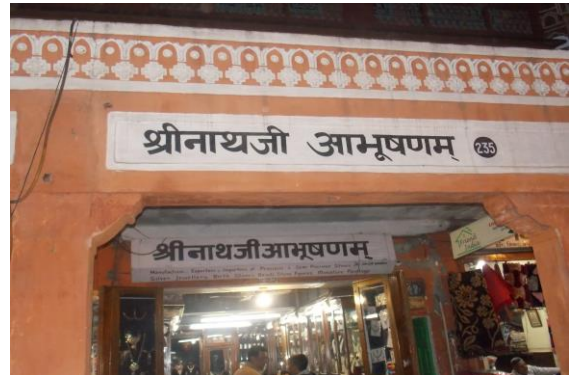
Photo 2
View of Shop No.235, Ground Floor

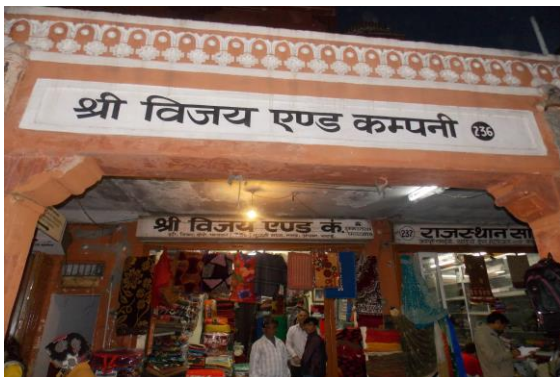
Photo 3
View of Shop No.236, Ground Floor

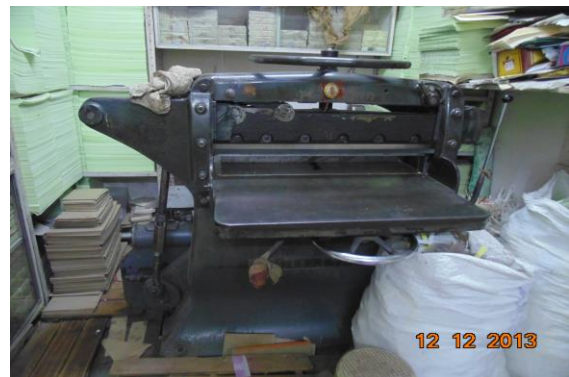
Photo 4
View of Heavy Machinery, Basement

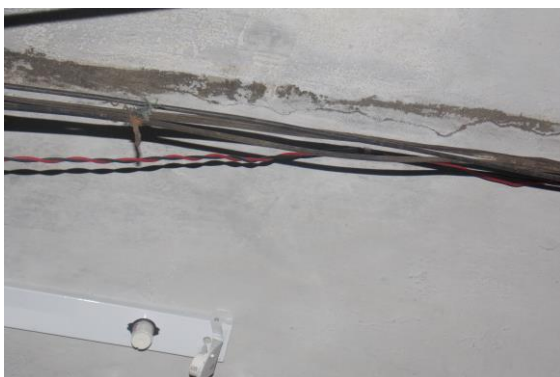
Summary of Cracks						
Defect ID	Location	Orientation	Appx. Width (mm)	Appx. Length (m)	Category	Photo No.
1	Roof Varanda of Shop No.235 Ground Floor	Horizontal	2	2.5	Slight	5
2	Roof Varanda of Shop No.236 Ground Floor	Horizontal	3	2.5	Slight	6

Photo 5
Horizontal Crack on Roof of Varanda of Shop No.235, Ground Floor, Approx. Width = 2mm, Approx. Length = 2.5m. Distance from Left side External Column = Backside, Height from Floor = 3m.

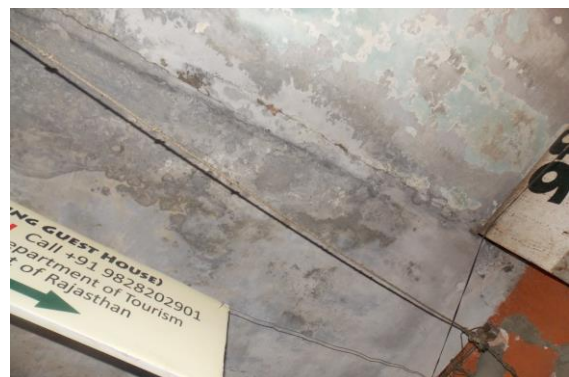
Photo 6
Horizontal Crack on Roof of Varanda of Shop No.236, Ground Floor, Approx. Width = 3mm, Approx. Length = 2.5m. Distance from Left side External Column = Backside, Height from Floor = 3m.

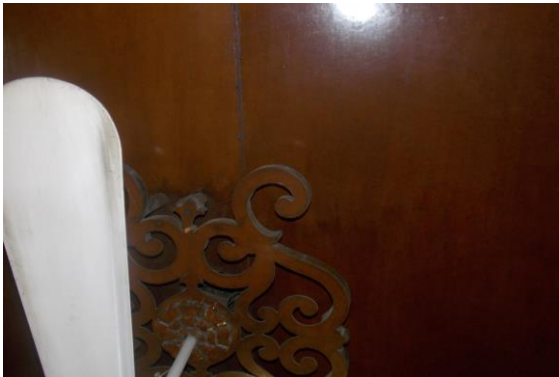
Photo 7
Plaster Crack on Floor of Shop No.235 of Ground Floor

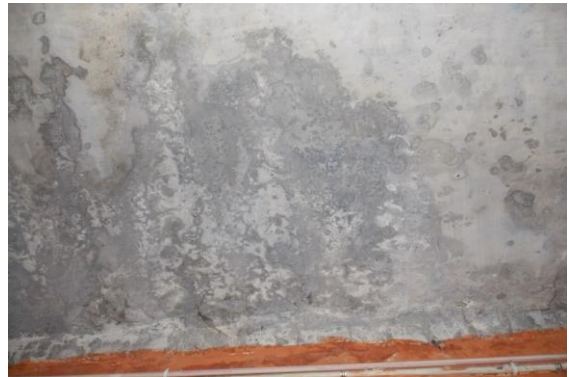
Photo 8
Dampness/Seepage on Roof of Varanda of Shop No.235 of Ground Floor

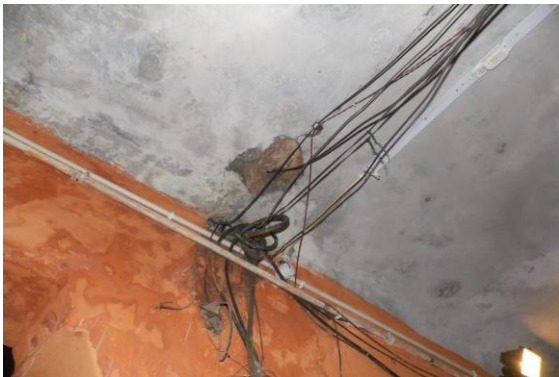
Photo 9
Damaged Portion on Roof of Varanda of Shop No.235 of Ground Floor

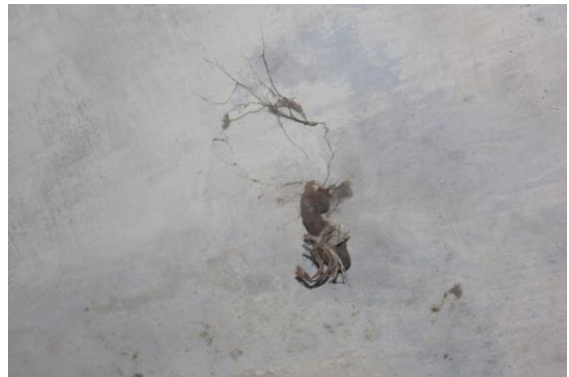
Photo 10
Peeling of Plaster on Roof of Varanda of Shop No.235 of Ground Floor

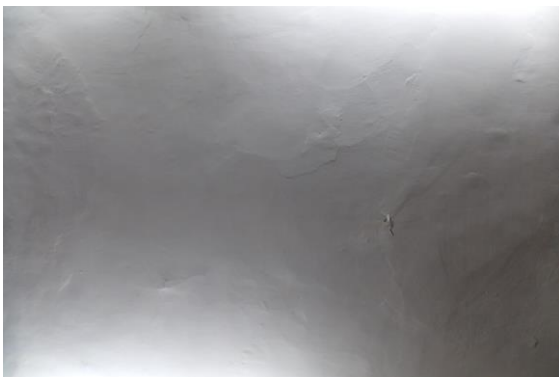
Photo 11
Plaster Crack on Roof of Part A of Shop No.236 of Ground Floor

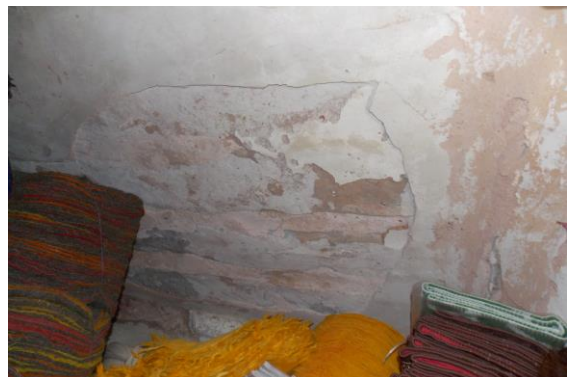
Photo 12
Damaged Portion on Roof of Part B of Shop No.236 of Ground Floor

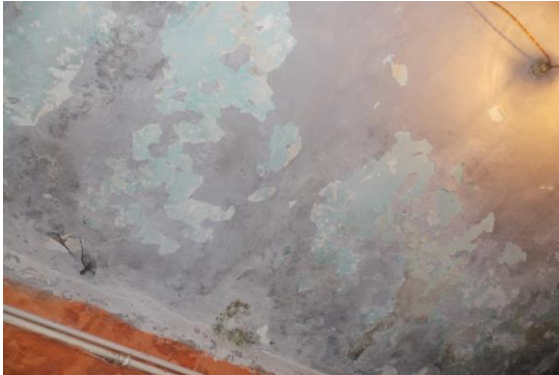
Photo 13

Dampness/Seepage on Roof of Varanda of Shop No.236 of Ground Floor

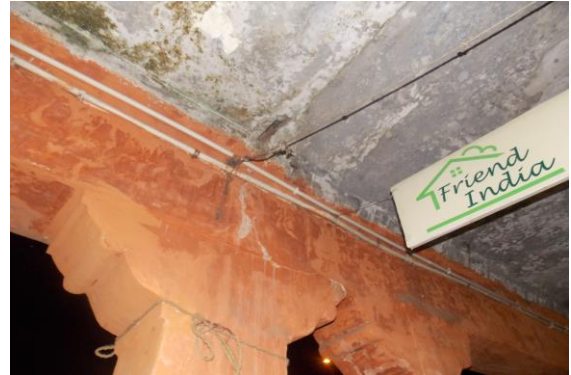
Photo 14

Damaged Portion on Roof of Varanda of Shop No.236 of Ground Floor
