Pre Building Condition Survey Report

Name and Address of Structure :	Choti Chopar to Badi Chopar (Down Line)
---------------------------------	---

Name of the Project	Contract JMRC-UG1B “Design and Construction of Tunnel between Chandpole and Badi Chouper and reverse line by Shield TBM, Underground Metro Stations at Choti Chouper and Badi Chouper by Cut and Cover Methods on East West Corridor of Jaipur Metro Rail Corporation Limited .”	
Owner :

Pre Building Condition Survey Report Choti Chopar to Badi Chopar (Down Line)

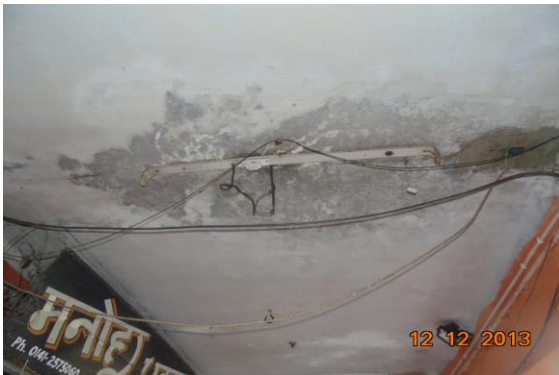
Photo 15

Dampness/Seepage on Roof of Varanda of Shop No.233 of Ground Floor

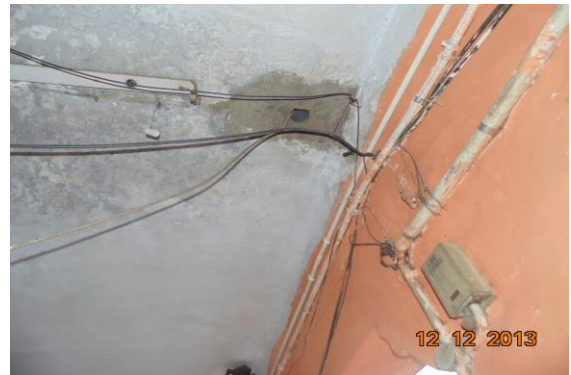
Photo 16

Dampness/Seepage on Roof of Varanda of Shop No.233 of Ground Floor

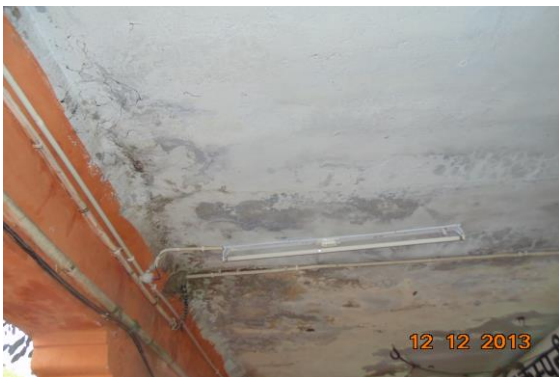
Photo 17

Peeling of Plaster on Roof of Varanda of Shop No.233 of Ground Floor

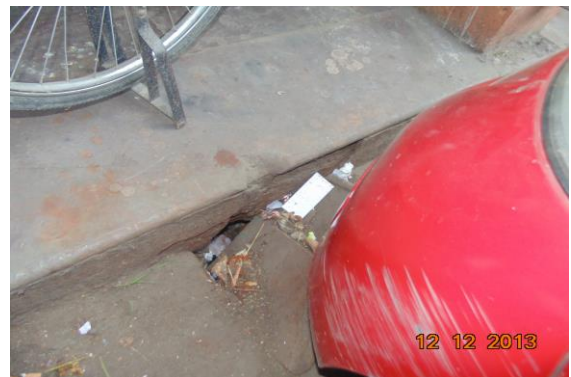
Photo 18

Damaged Portion on Floor of Varanda of Shop No.233 of Ground Floor

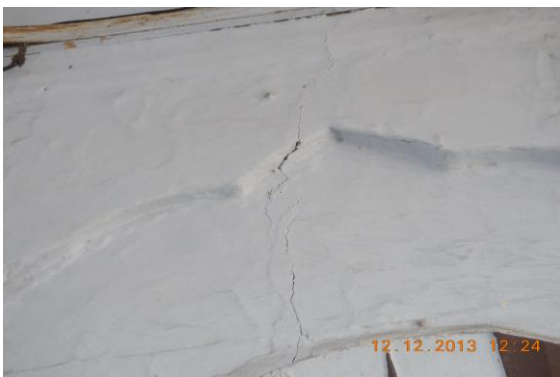
Photo 5
Inclined Crack on of Open Sky, House No. 483, First Floor
Approx. Width = 0.4mm, Approx. Length = 0.9m.
Distance from W1 = 1m, Height from Floor = 2.2m.

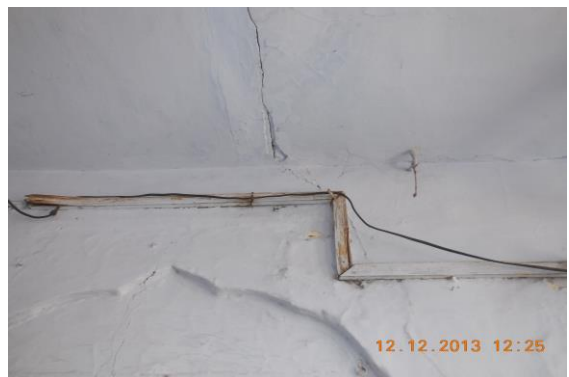
Photo 6
Inclined Crack on Wall No.4 & Sunshade of Open Sky, House No. 483,
First Floor Approx. Width = 5mm, Approx. Length = 2.5m. Distance from
w1 = 1.6m, Height from Floor = 2.5m.

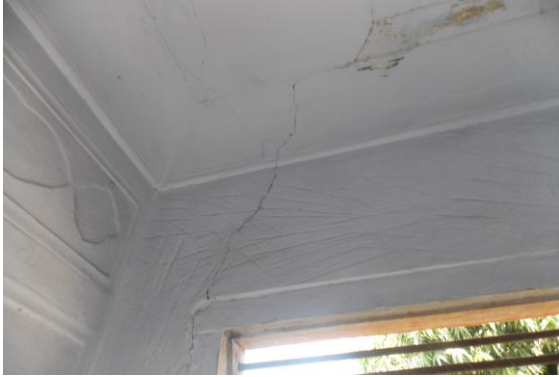
Photo 7

Inclined Crack on Wall No.4 & Roof of Varanda, House No. 483, First Floor Approx. Width = 2mm, Approx. Length = 2m. Distance from w1 = 2.7m, Height from Floor = 1.9m.

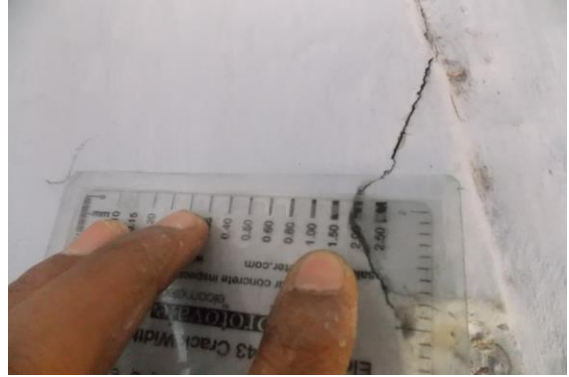
Photo 7A

Inclined Crack on Wall No.4 & Roof of Varanda, House No. 483, First Floor Approx. Width = 2mm, Approx. Length = 2m. Distance from w1 = 2.7m Height from Floor = 1.9m.

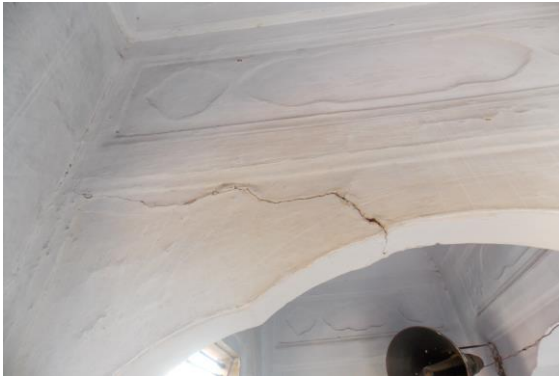
Photo 8

Inclined Crack on Wall No. 2 & Roof of Varanda, House No. 483, First Floor Approx. Width = 8mm, Approx. Length = 0.8m. Distance from w4 = 0.3m, Height from Floor = 2.1m.

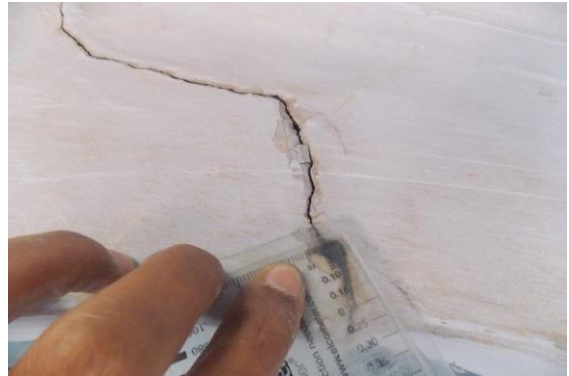
Photo 8A

Inclined Crack on Wall No. 2 & Roof of Varanda, House No. 483, First Floor Approx. Width = 8mm, Approx. Length = 0.8m. Distance from w4 = 0.3m, Height from Floor = 2.1m.

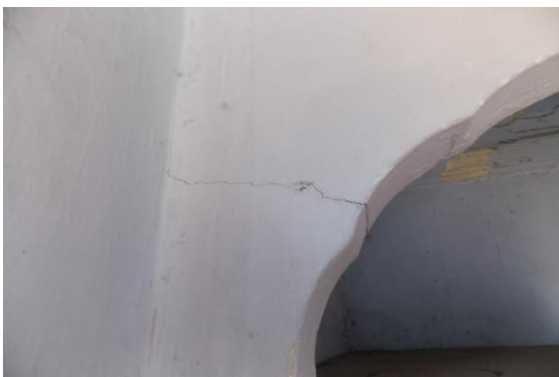
Photo 9

Inclined Crack on Varanda, House No. 483, First Floor Approx. Width = 0.4mm, Approx. Length = 0.3m. Distance from W4 = 0.2m, Height from Floor = 2m.

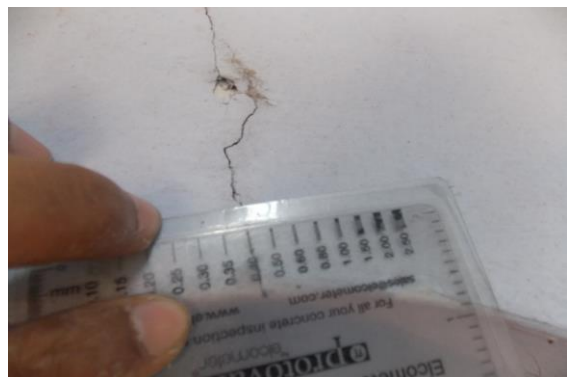
Photo 9A

Inclined Crack on Varanda, House No. 483, First Floor Approx. Width = 0.4mm, Approx. Length = 0.3m. Distance from W4 = 0.2m, Height from Floor = 2m.

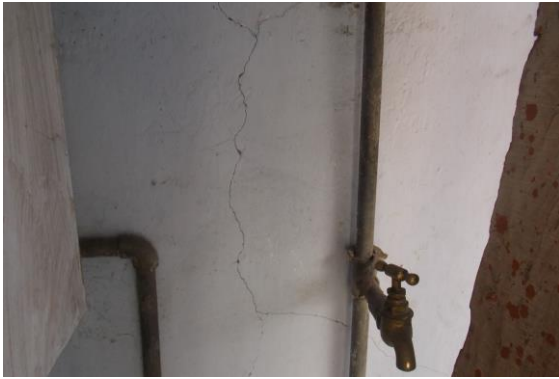
Photo 10

Inclined Crack on Wall No.2 & Roof of Varanda, House No. 483, First Floor Approx. Width = 0.2mm, Approx. Length = 2m. Distance from = m, Height from Floor = 0.5m.

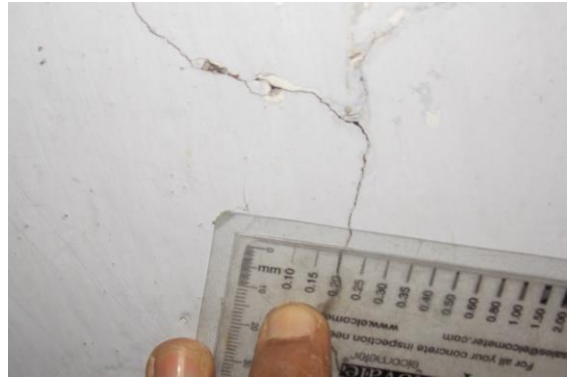
Photo 10A

Inclined Crack on Wall No.2 & Roof of Varanda, House No. 483, First Floor Approx. Width = 0.2mm, Approx. Length = 2m. Distance from = m, Height from Floor = 0.5m.

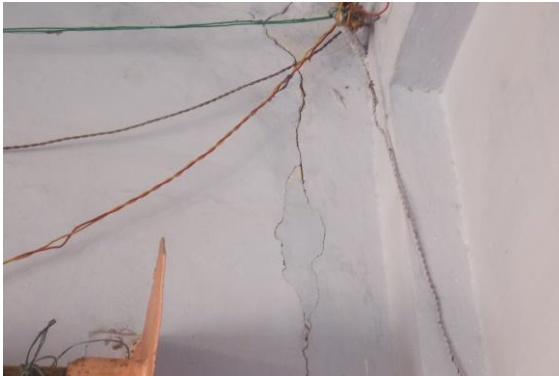
Photo 11

Vertical Crack on Sky open, House No. 483, First Floor Approx. Width = 0.5mm, Approx. Length = 3.5m. Distance from W1 = 0.5m, Height from Floor = 0m.

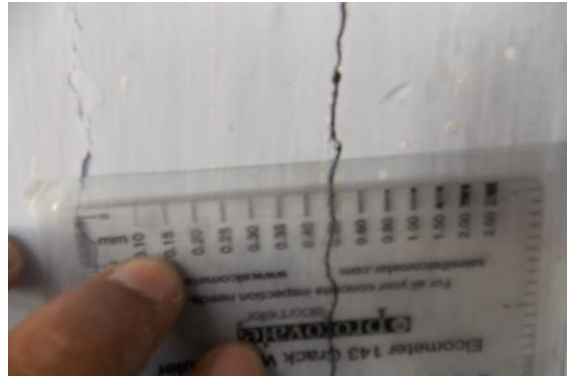
Photo 11A

Vertical Crack on Sky open, House No. 483, First Floor Approx. Width = 0.5mm, Approx. Length = 3.5m. Distance from W1 = 0.5m, Height from Floor = 0m.

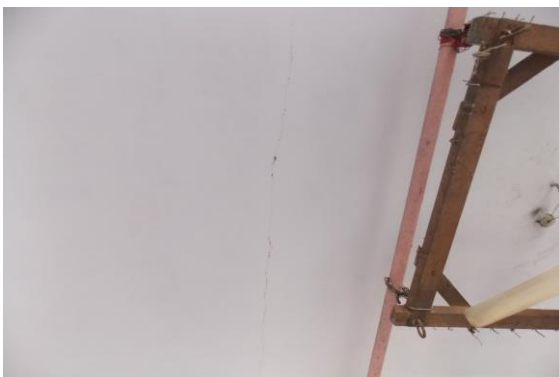
Photo 12

Horizontal Crack on Roof of Varanda 2, House No. 483, First Floor Approx. Width = 0.35mm, Approx. Length = 2.5m. Distance from W1 = 1.6m, Height from Floor = 2.2m.

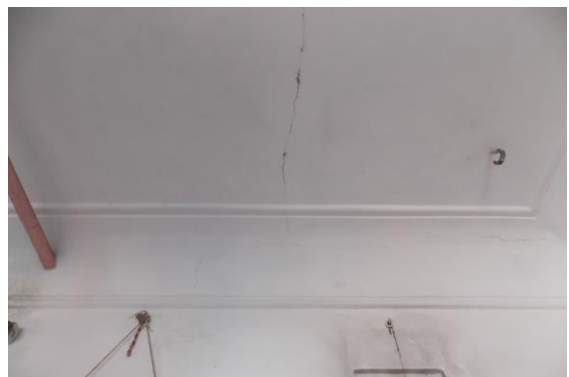
Photo 13

Horizontal Crack on Wall No.4 & Roof of Varanda 2, House No. 483, First Floor Approx. Width = 0.4mm, Approx. Length = 2m. Distance from W2 = 1.5m, Height from Floor = 2.2m.

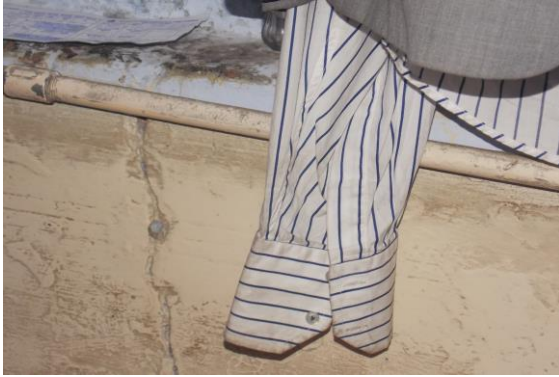
Photo 14

Horizontal Crack on Roof of Room No. 1, Temple, First Floor
Approx. Width = 2.5mm, Approx. Length = 0.5m.
Distance from W3 = 3.5m, Height from Floor = 0.4m.

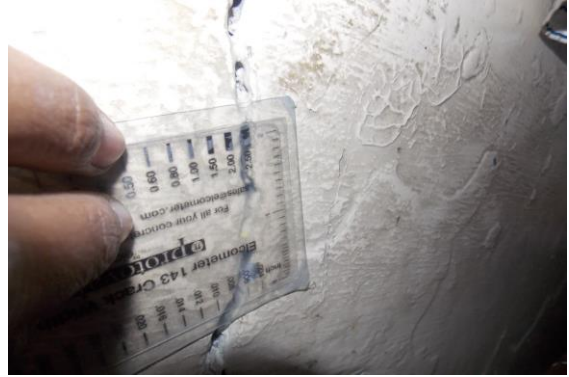
Photo 14A

Horizontal Crack on Roof of Room No. 1, Temple, First Floor
Approx. Width = 2.5mm, Approx. Length = 0.5m.
Distance from W3 = 3.5m, Height from Floor = 0.4m.

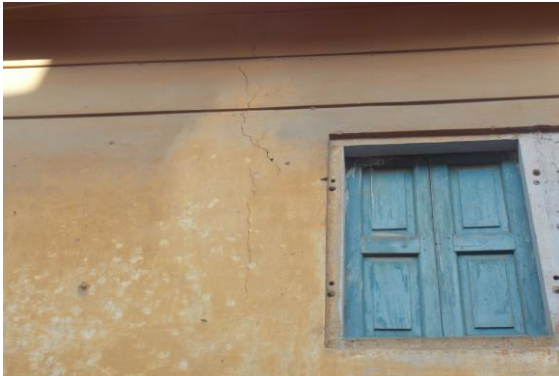
Photo 15

Inclined Crack on Back Side, House No. 483, Ground Floor
Approx. Width = 2mm, Approx. Length = 2m.
Distance from Left Side of Building = 1m, Height from Floor = 2.8m.

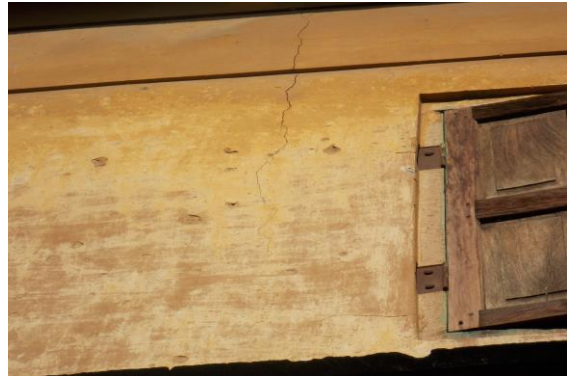
Photo 16

Inclined Crack on Back Side, House No. 483, Ground Floor
Approx. Width = 1.8mm, Approx. Length = 1m.
Distance from Left Side of Building = 1.8m, Height from Floor = 5m.

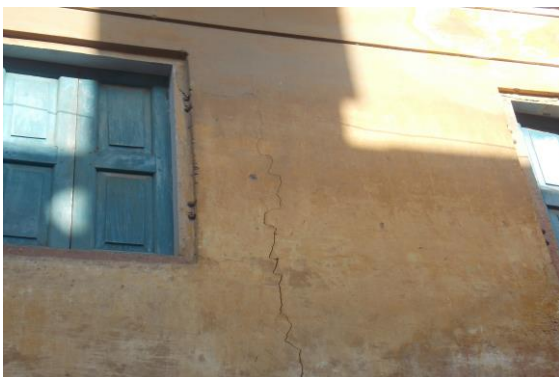
Photo 17

Inclined Crack on Back Side, House No. 483, Ground Floor
Approx. Width = 1mm, Approx. Length = 1.2m.
Distance from Left Side of Building = 1.2m, Height from Floor = 2m.

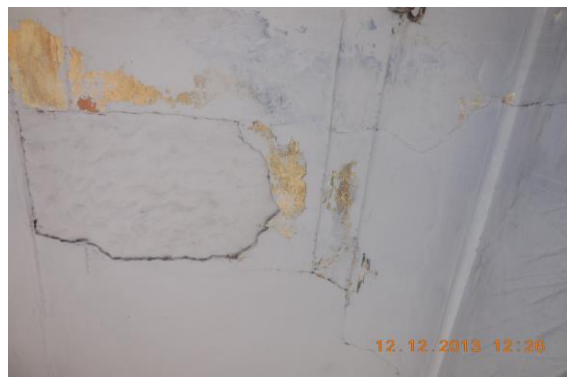
Photo 18

Peeling of Plaster on Roof of Varanda of House No. 483, First Floor

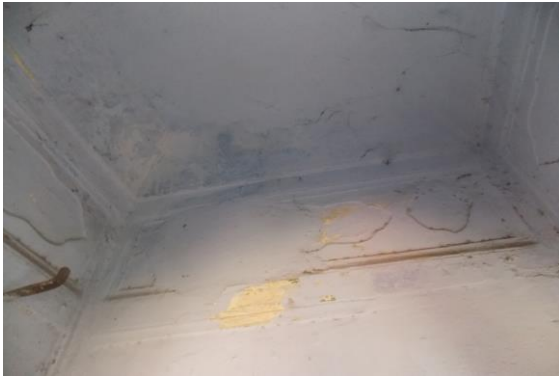
Photo 19

Peeling of Plaster on Wall No.2 & Roof of Varanda of House No. 483, First Floor

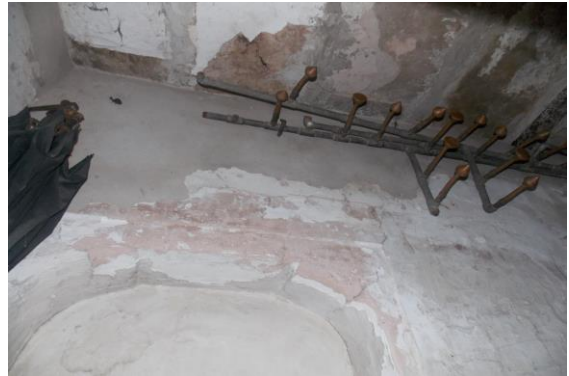
Photo 20

Damaged Portion on Wall No.4 & Roof of Store of House No. 483, First Floor

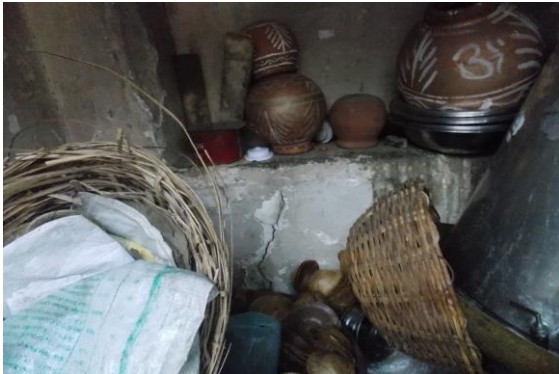
Photo 21

Damaged Portion on Wall No.4 & Roof of Store of House No. 483, First Floor

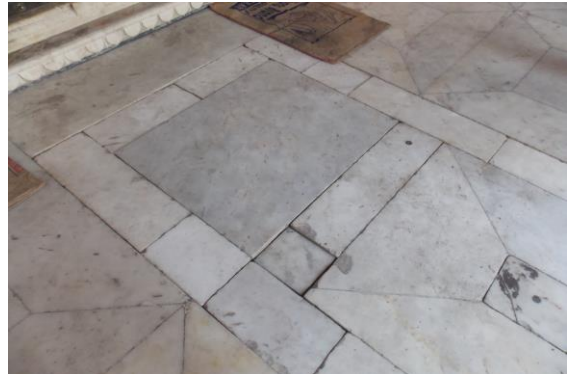
Photo 22

Dampness/Seepage on Floor of Varanda 2 of House No. 483, First Floor

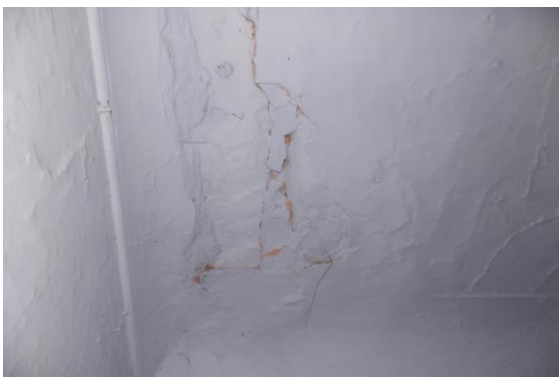
Photo 23

Peeling of Plaster on Roof of Room No. 1 of Temple, First Floor

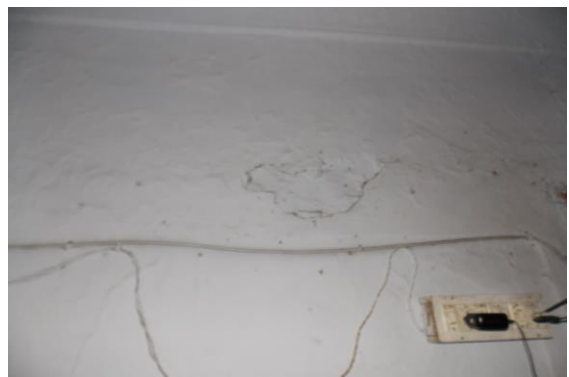
Photo 24

Peeling of Plaster on Roof of Room No. 1 of Temple, First Floor

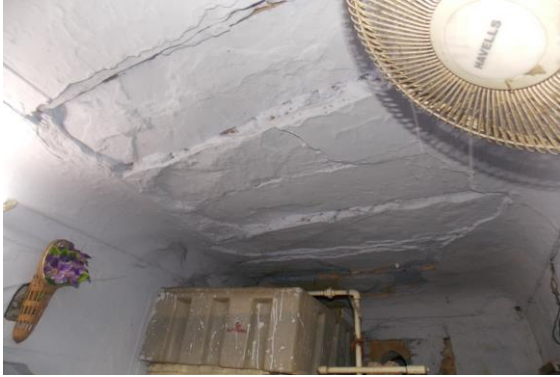
Photo 25
Damaged Portion on Roof of Room No. 1 of Temple, First Floor

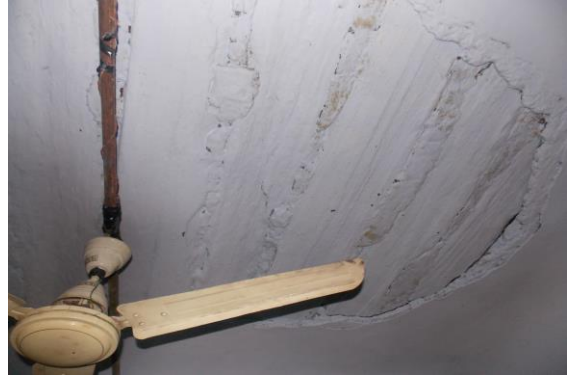
Photo 26
Dampness/Seepage on Roof of Room No. 2 of Temple, First Floor

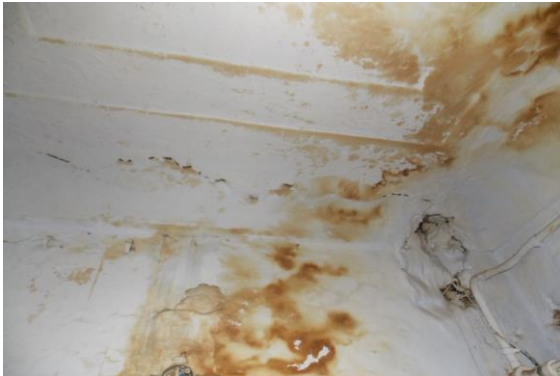
Photo 27
Dampness/Seepage on Wall No. 2 & Roof of Kitchen of House No. 483, First Floor

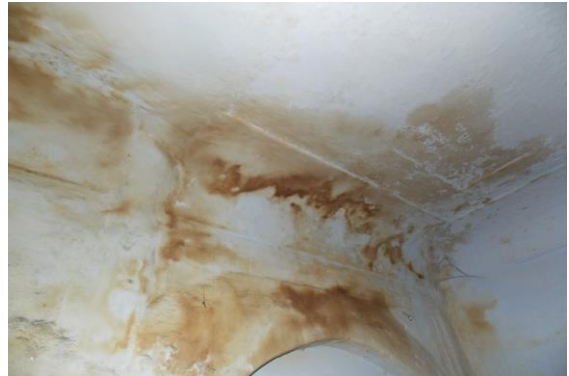
Photo 28
Dampness/Seepage on Wall No.3 & Roof of Kitchen of House No. 483, First Floor

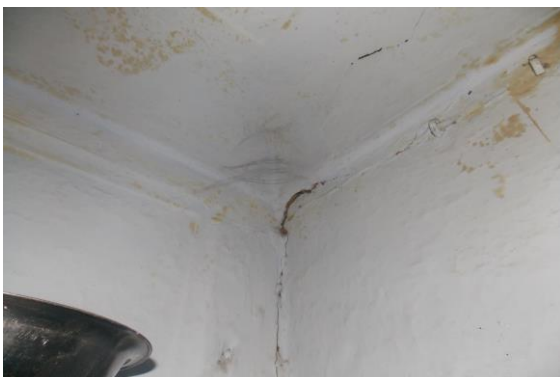
Photo 29
Peeling of Plaster on Wall No.3 & Roof of Kitchen of House No. 483, First Floor

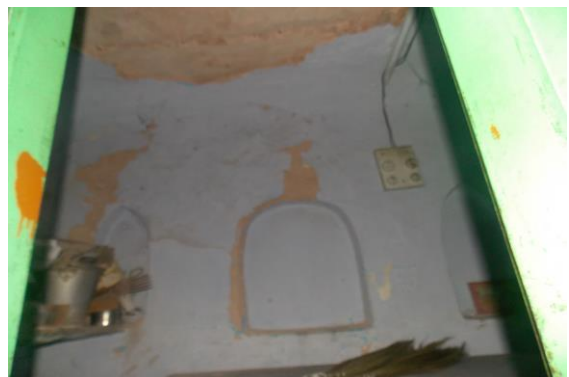
Photo 30
Peeling of Plaster on Wall No.4 & Roof of Room No. 3 of House No. 483, First Floor

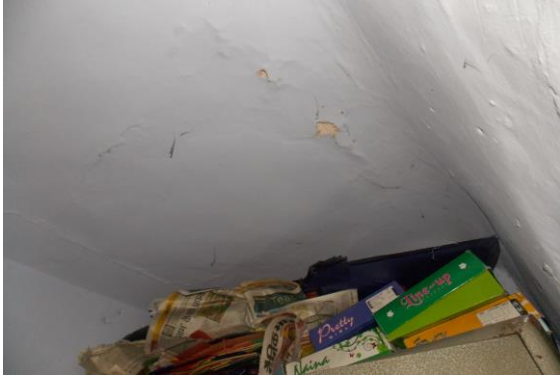
Photo 31

Peeling of Plaster on Roof of Room No. 4 of House No. 483, First Floor

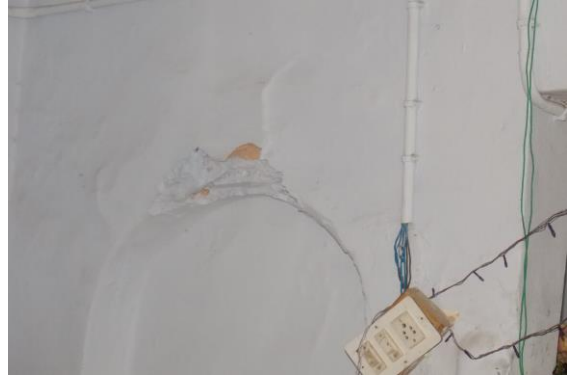
Photo 32

Peeling of Plaster on Roof of Lobby1 of House No. 483, First Floor

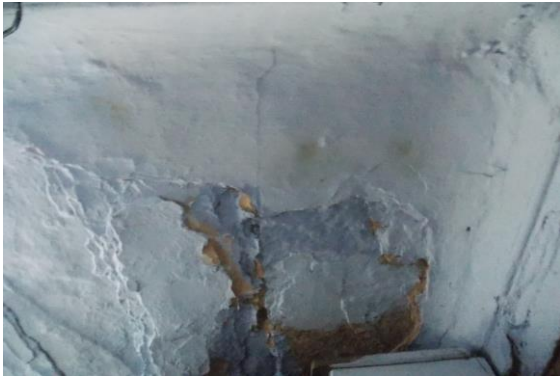
Photo 33

Dampness/Seepage on Roof of Bathroom of House No. 483, First Floor

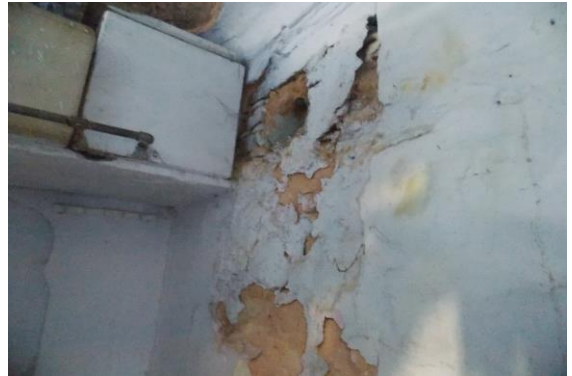
Photo 34

Dampness/Seepage on Roof of Bathroom of House No. 483, First Floor

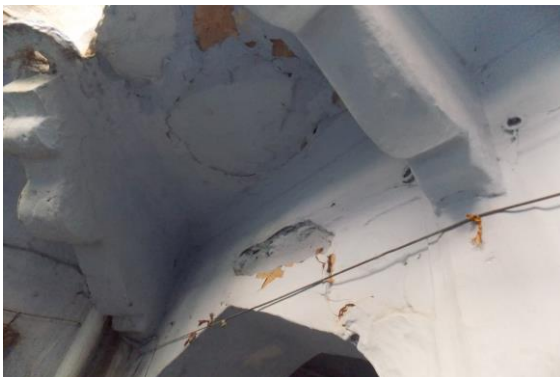
Photo 35

Peeling of Plaster on Wall No.1 & Roof of Varanda 3 of House No. 483, First Floor

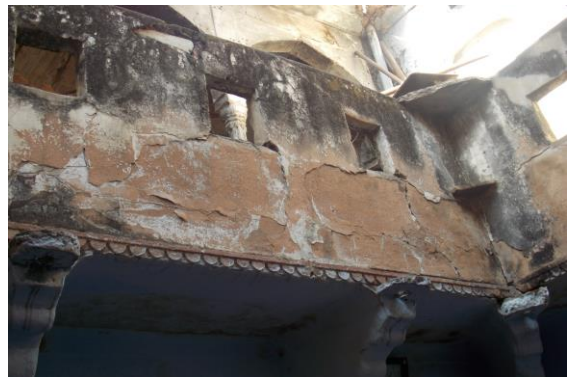
Photo 36

Dampness/Seepage on All Parapet wall of Varanda 3 of House No. 483, First Floor

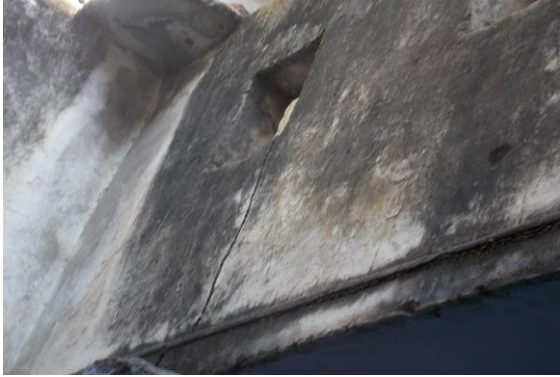
Photo 37

Dampness/Seepage on All parapet wall of Varanda 3 of House No. 483, First Floor

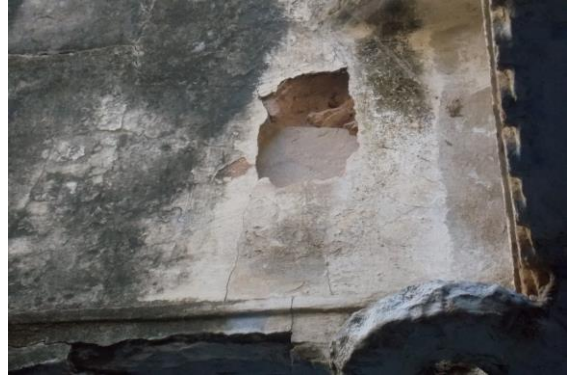
Photo 38

Dampness/Seepage on All parapet wall of Varanda 3 of House No. 483, First Floor

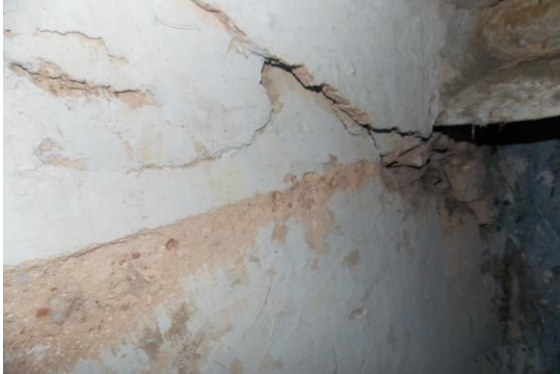
Photo 39

Dampness/Seepage on All parapet wall of Stair Case of House No. 483, First Floor

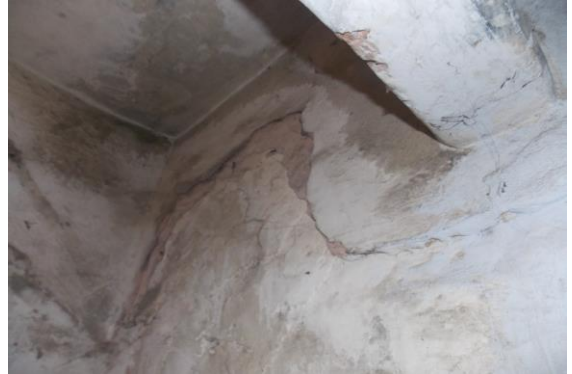
Photo 40

Dampness/Seepage on All parapet wall of Stair Case of House No. 483, First Floor

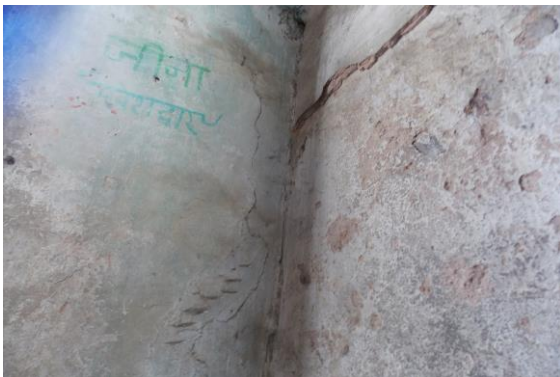
Photo 41

Dampness/Seepage on All parapet wall of Stair Case of House No. 483, Second Floor

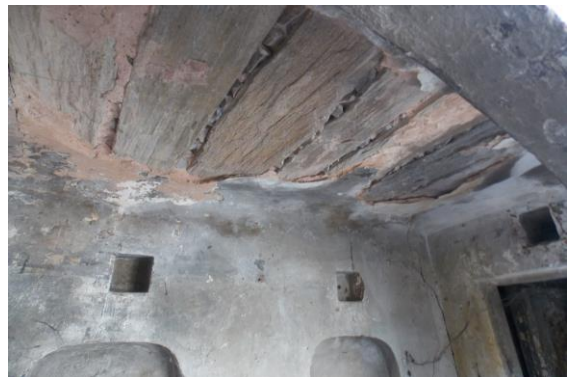
Photo 42

Dampness/Seepage on Lobby2 of House No. 483, Second Floor

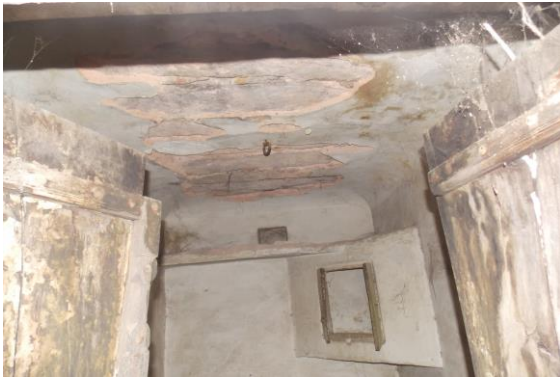
Photo 43

Dampness/Seepage on Room No. 1 of House No. 483, Second Floor

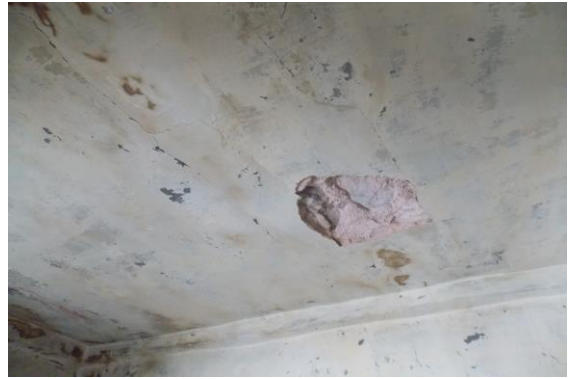
Photo 44

Peeling of Plaster on Roof of Lobby-1 of House No. 483, Second Floor

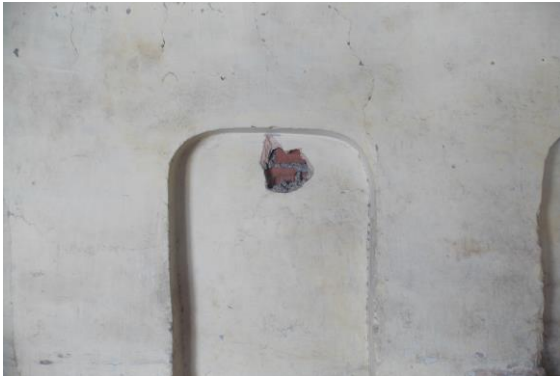
Photo 45

Peeling of Plaster on Roof of Lobby-1 of House No. 483, Second Floor

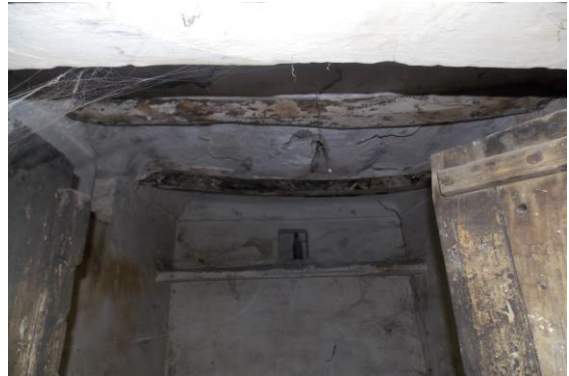
Photo 46

Dampness/Seepage on Room No. 3 of House No. 483, Second Floor

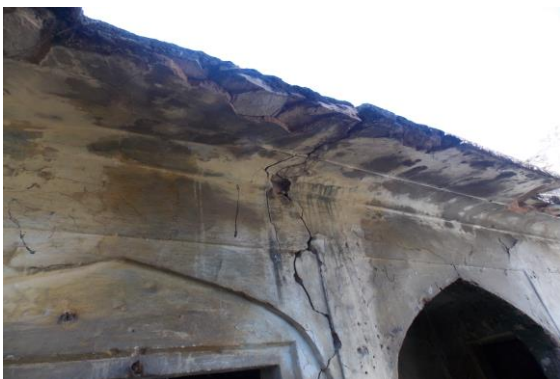
Photo 47

Dampness/Seepage on All Wall of Open Sky of House No. 483, Second Floor

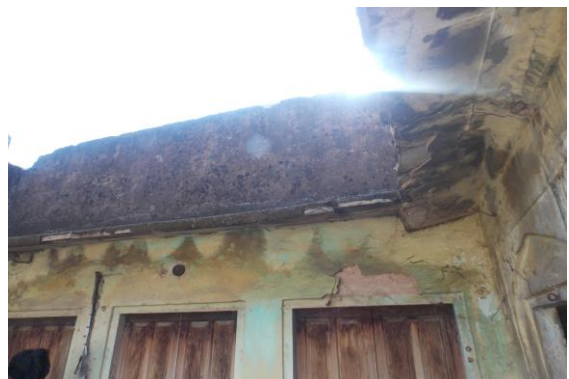
Photo 48

Dampness/Seepage on All Wall of Open Sky of House No. 483, Second Floor

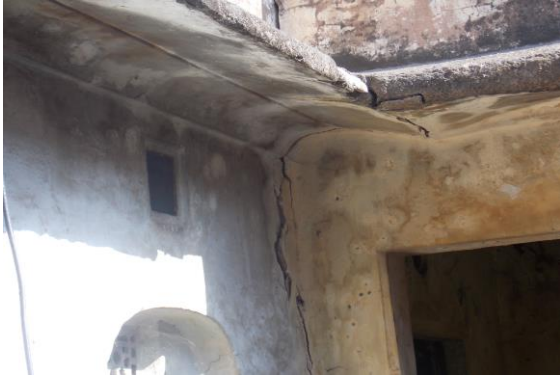
Photo 49

Dampness/Seepage on All Wall of Open Sky of House No. 483, Second Floor

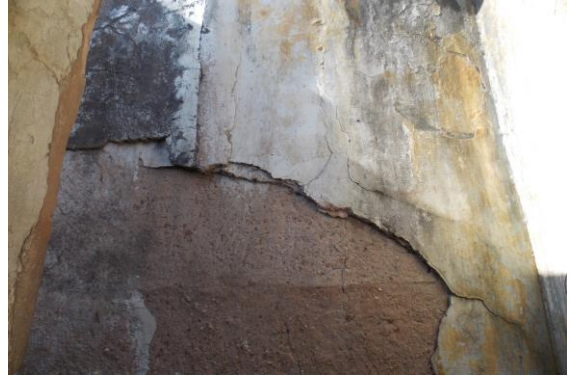
Photo 50

Dampness/Seepage on All Wall of Stair Case Second Floor to Terrace of House No. 483, Second Floor

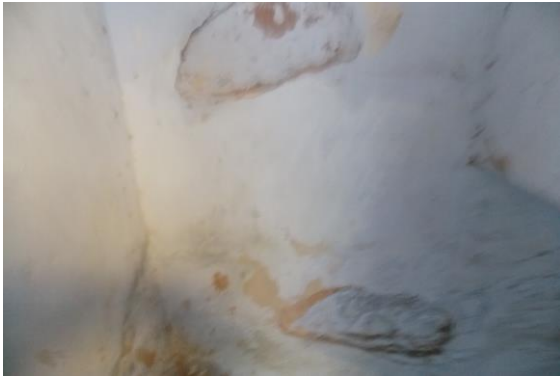
Photo 51

Peeling of Plaster on All Wall of Stair Case Ground Floor to First Floor of House No. 483, Ground Floor

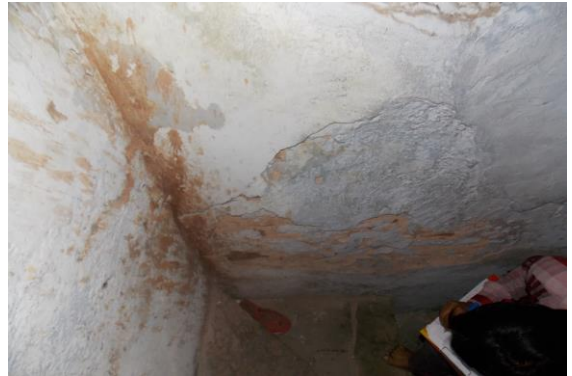
Photo 52

Peeling of Plaster on All Wall of Stair Case Ground Floor to First Floor of House No. 483, Ground Floor

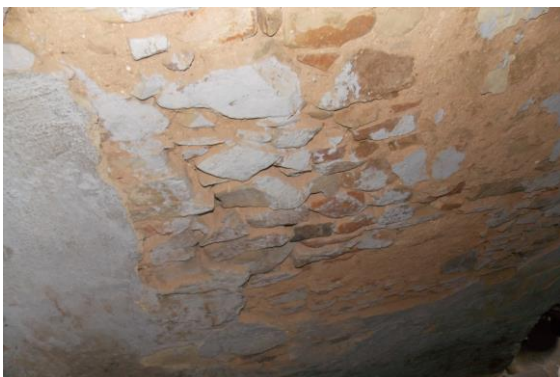
Photo 53

Dampness/Seepage on All Wall of Stair Case Ground Floor to First Floor of House No. 483, Ground Floor

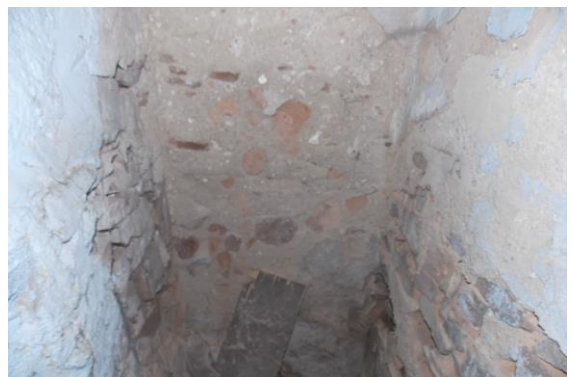
Photo 54

Dampness/Seepage on All Wall of Stair Case Ground Floor to First Floor of House No. 483, Ground Floor

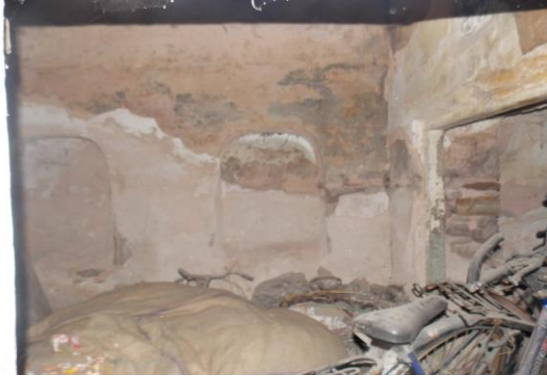
Photo 55

Dampness/Seepage on Room No. 1 & 2 of House No. 483, Ground Floor

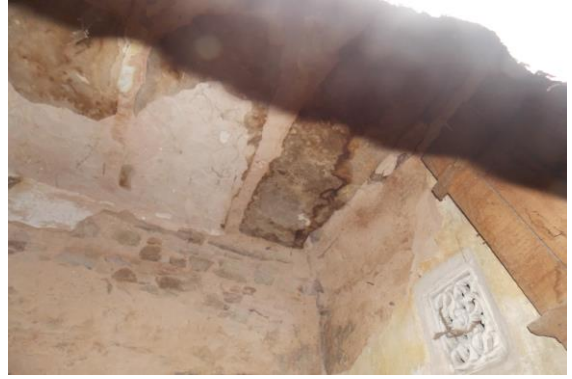
Photo 56

Dampness/Seepage on Room No. 1 & 2 of House No. 483, Ground Floor

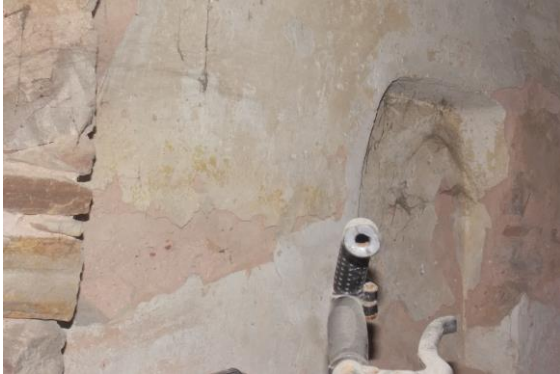
Photo 57

Dampness/Seepage on Room No. 1 & 2 of House No. 483, Ground Floor

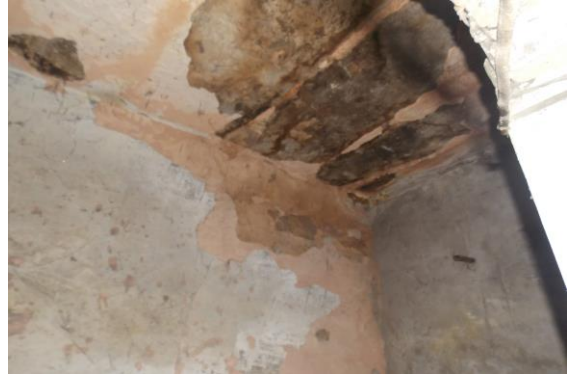
Photo 58

Dampness/Seepage on Room No. 4 of House No. 483, Ground Floor

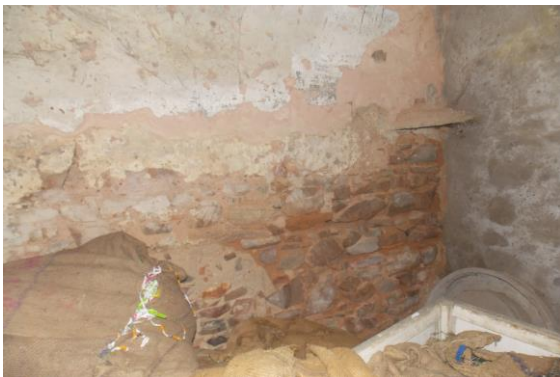
Photo 59

Dampness/Seepage on Room No. 4 of House No. 483, Ground Floor

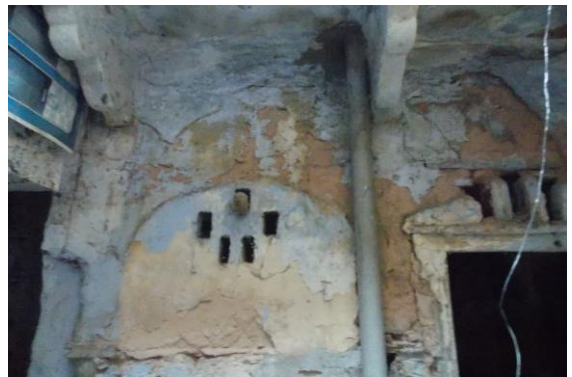
Photo 60

Dampness/Seepage on Sky open of House No. 483, Ground Floor

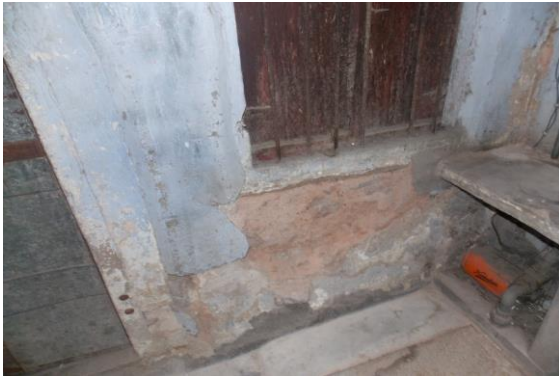
Photo 61

Dampness/Seepage on Sky open of House No. 483, Ground Floor

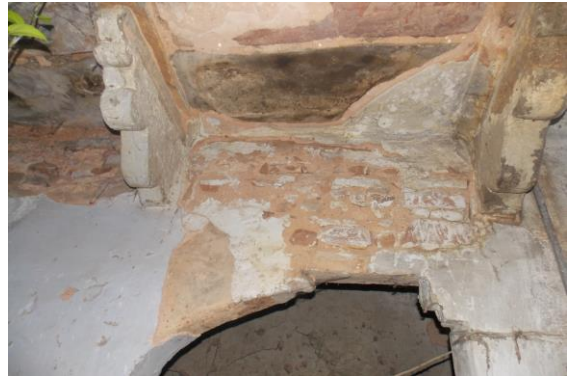
Photo 62

Dampness/Seepage on Sky open of House No. 483, Ground Floor

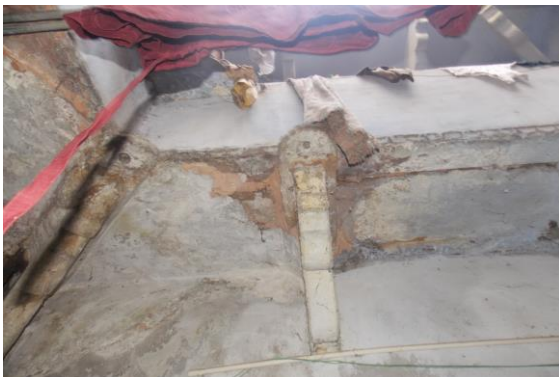
Photo 63

Dampness/Seepage on Sky Open Sunshade of House No. 483, Ground Floor

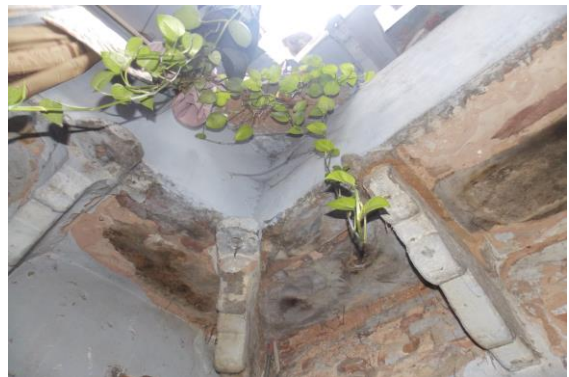
Photo 64

Dampness/Seepage on Sky Open Sunshade of House No. 483, Ground Floor

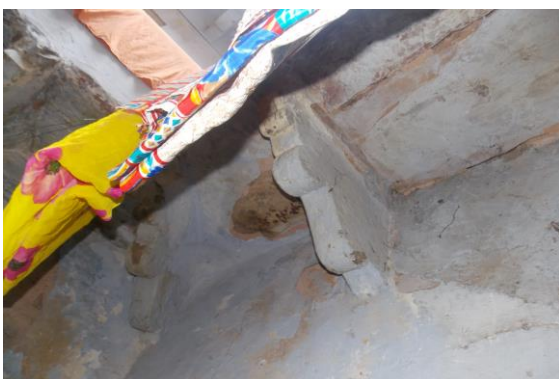
Photo 65

Dampness/Seepage on Sky Open Sunshade of House No. 483, Ground Floor

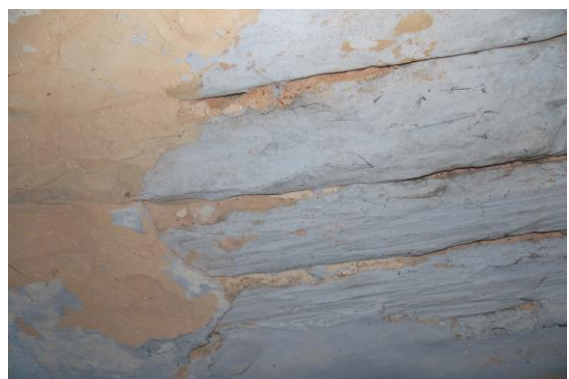
Photo 66

Dampness/Seepage on Roof of Lobby of House No. 483, Ground Floor

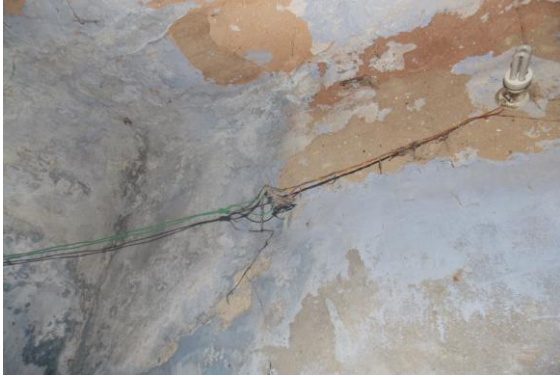
Photo 67

Dampness/Seepage on Roof of Lobby of House No. 483, Ground Floor

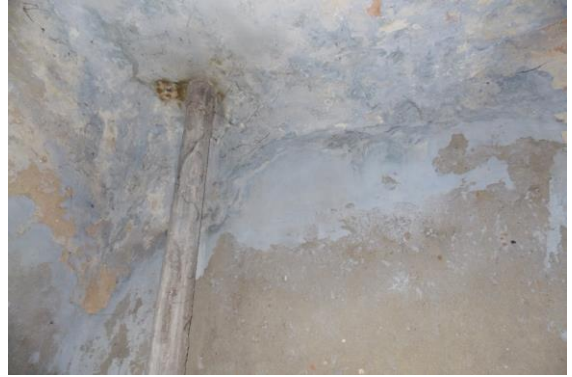
Photo 68

Dampness/Seepage on Roof of Lobby of House No. 483, Ground Floor

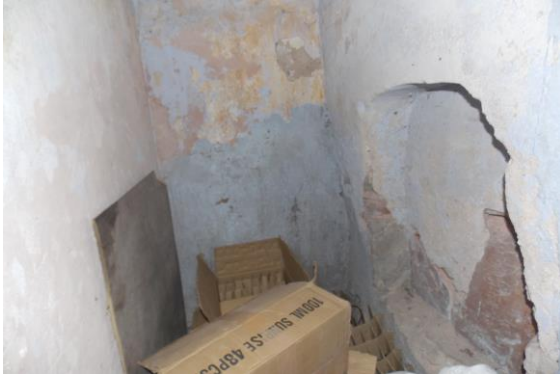
Photo 69

Dampness/Seepage on Wall No. All Wall of Bathroom No. of House No. 483, Ground Floor

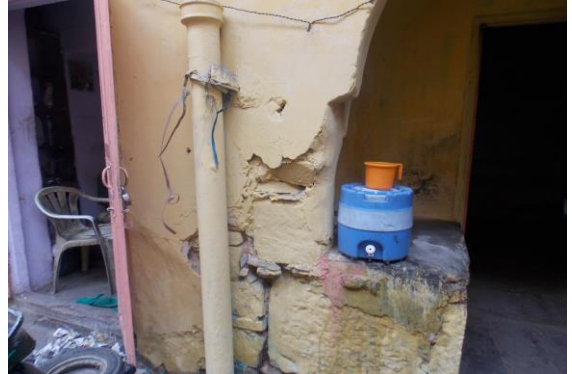
Photo 70

Dampness/Seepage on Back Side of House No. 483, Ground Floor

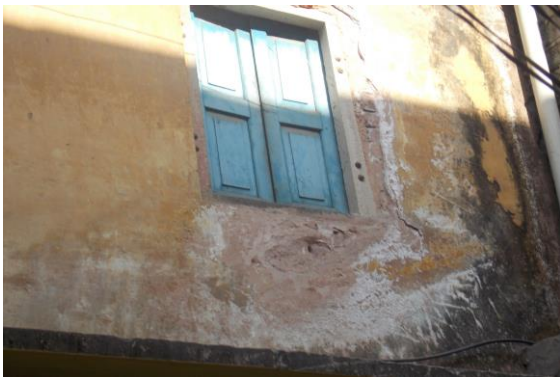
Photo 71

Peeling of Plaster on Back Side of House No. 483, Ground Floor

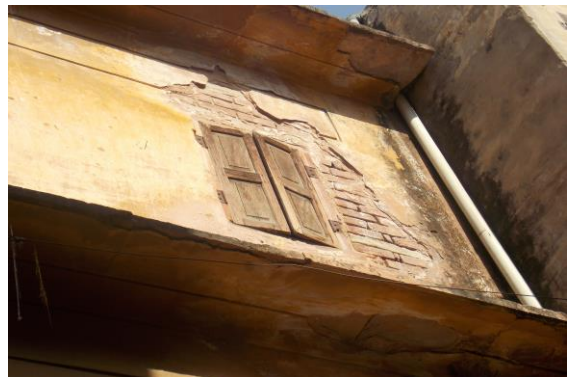
Photo 72

Peeling of Plaster on Back Side of House No. 483, Ground Floor

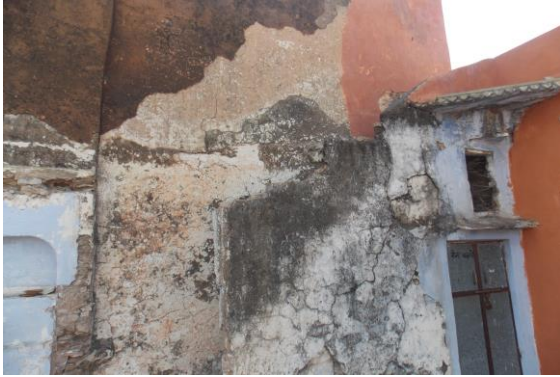
Photo 73

Dampness/Seepage on Main Stair Case of House No. 483, Ground Floor

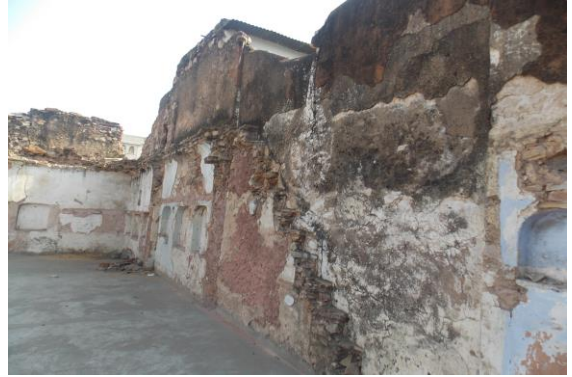
Photo 74

Dampness/Seepage on Main Stair Case of House No. 483, Ground Floor

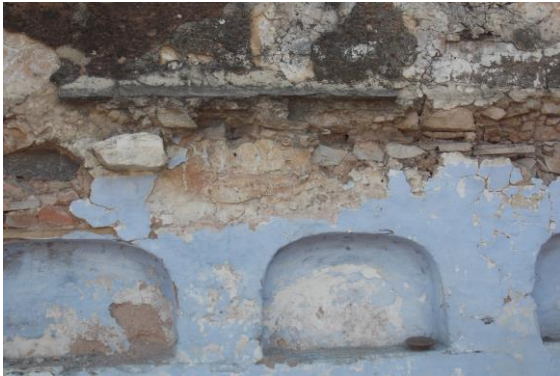
Photo 75

Dampness/Seepage on Main Stair Case of House No. 483, Ground Floor

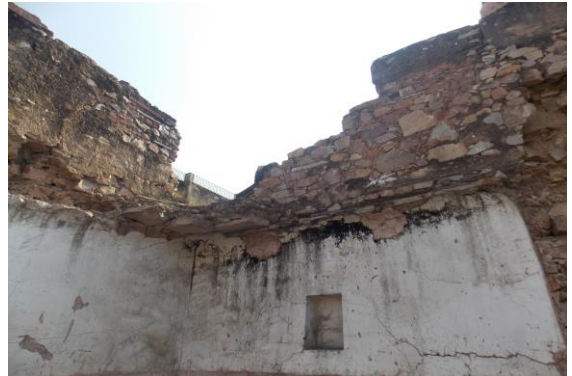
Photo 76

Dampness/Seepage on Main Stair Case of House No. 483, Ground Floor

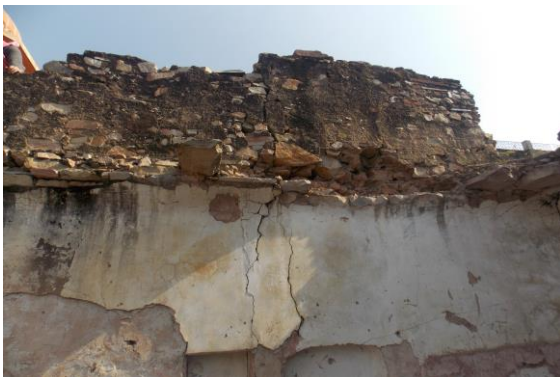
Photo 77

Dampness/Seepage on Main Stair Case of House No. 483, Ground Floor

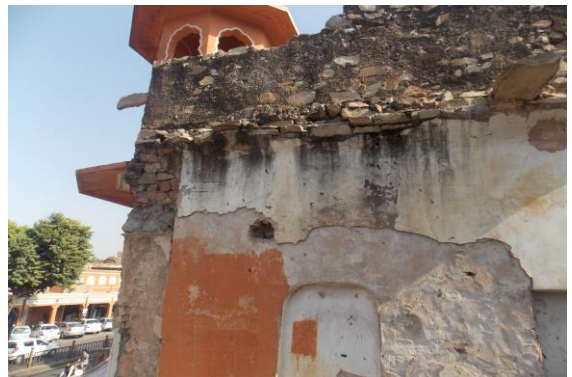
Photo 78

Dampness/Seepage on Main Stair Case of House No. 483, Ground Floor

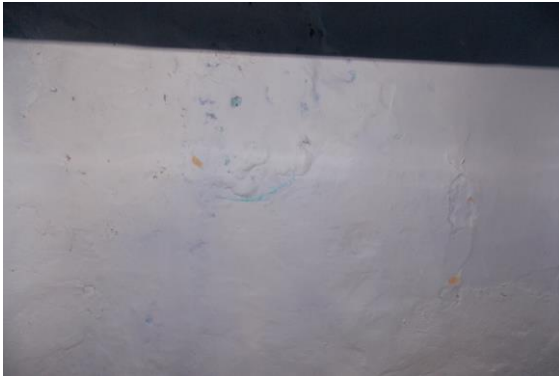
Photo 79
Peeling of Plaster on Roof of Shop of Ground Floor

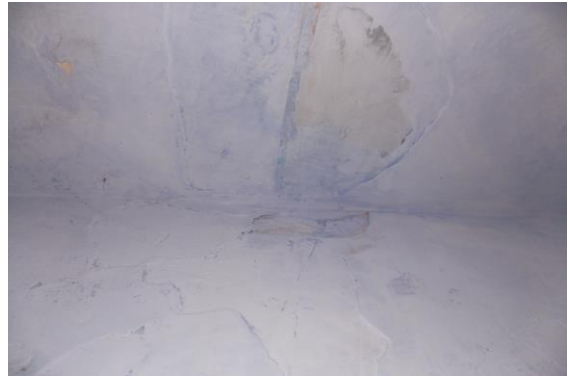
Photo 80
Peeling of Plaster on Wall No. 3 & Roof of Shop of Ground Floor

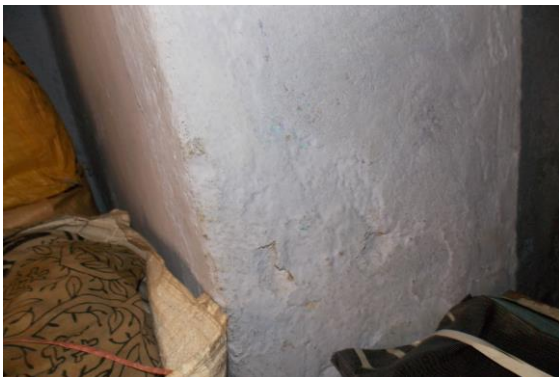
Photo 81
Peeling of Plaster on Wall No.3 & Roof of Shop of Ground Floor

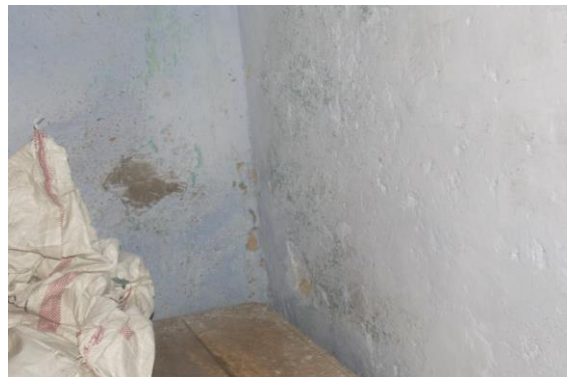
Photo 82
Peeling of Plaster on Wall No. 3 & Roof of Shop of Ground Floor

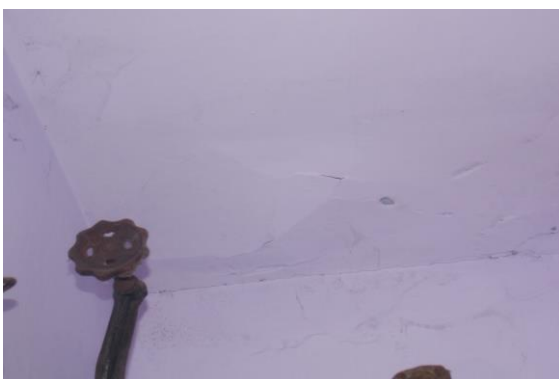
Photo 83
Peeling of Plaster on Roof of Shop No. 2 of Ground Floor

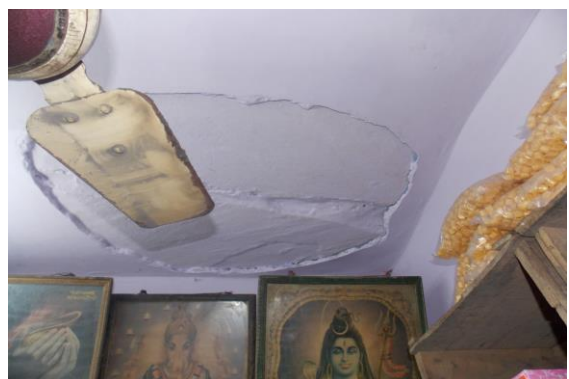
Photo 84
Peeling of Plaster on Roof of Shop No. 2 of Ground Floor

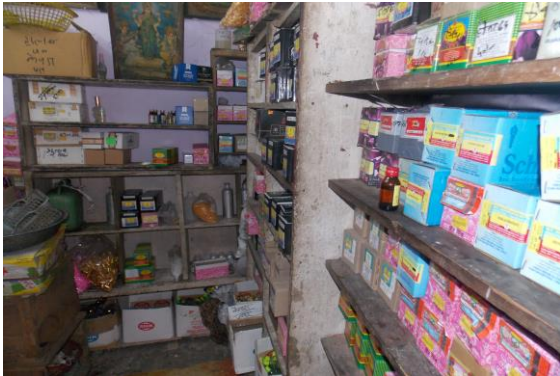
Photo 93
Roof of Shop No. 2 of Ground Floor Covered with Material

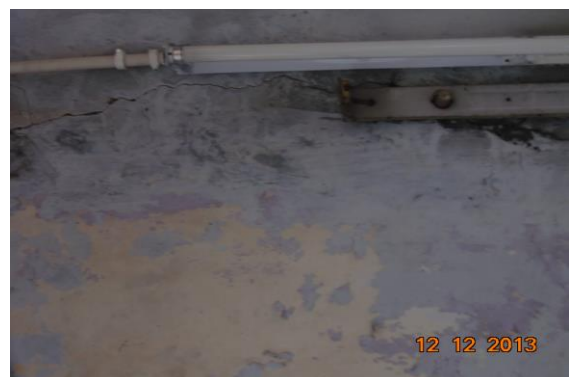
Photo 6
Horizontal Crack on Roof of Varanda , Shop No. 229, Ground Floor, Approx. Width = 2mm, Approx. Length = 2m.

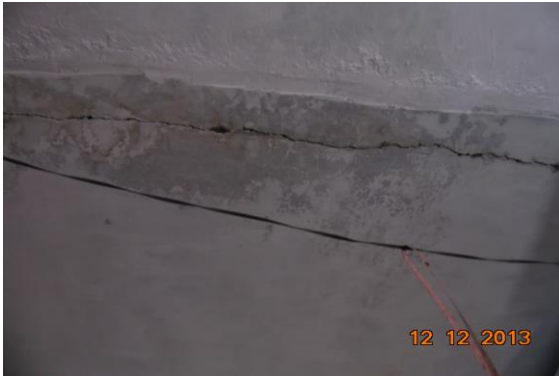
Photo 7

Horizontal Crack on Roof of Varanda , Shop No. 226, Ground Floor, Approx. Width = 3mm, Approx. Length = 3m. Distance from Left side External Column = 0m, Height from Floor = 3m.

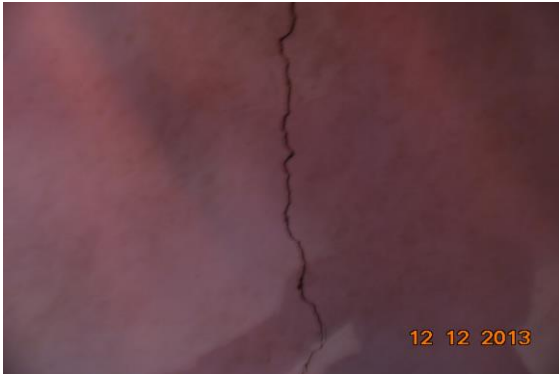
Photo 9

Vertical Crack on Wall No. 2 of Shop No. 225, Ground Floor, Approx. Width = 1.5mm, Approx. Length = 3.2m. Distance from Shop Door = 2m, Height from Floor = 0m.

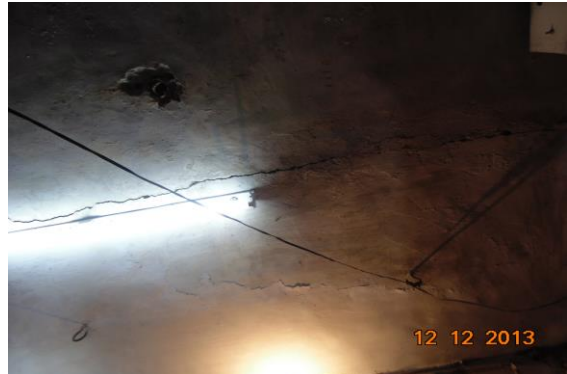
Photo 10

Horizontal Crack on Roof of Varanda , Shop No. 225, Ground Floor, Approx. Width = 4mm, Approx. Length = 3m. Distance from External Column = 0m, Height from Floor = 3.5m.
