Pre Building Condition Survey Report

Name and Address of Structure :	Choti Chopar to Badi Chopar (Down Line)
---------------------------------	---

Name of the Project	Contract JMRC-UG1B “Design and Construction of Tunnel between Chandpole and Badi Chouper and reverse line by Shield TBM, Underground Metro Stations at Choti Chouper and Badi Chouper by Cut and Cover Methods on East West Corridor of Jaipur Metro Rail Corporation Limited .”	
Owner :

Pre Building Condition Survey Report Choti Chopar to Badi Chopar (Down Line)

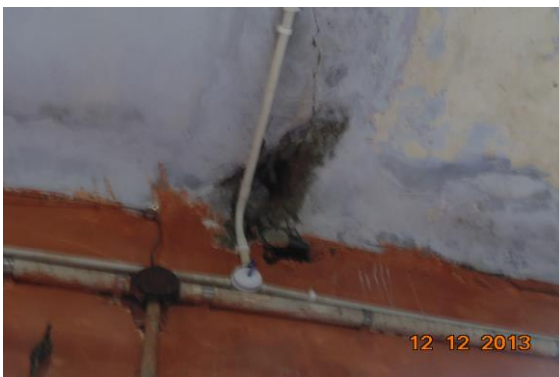
Photo 11

Damaged Portion on Roof of Varanda of Shop No. 229, Ground Floor

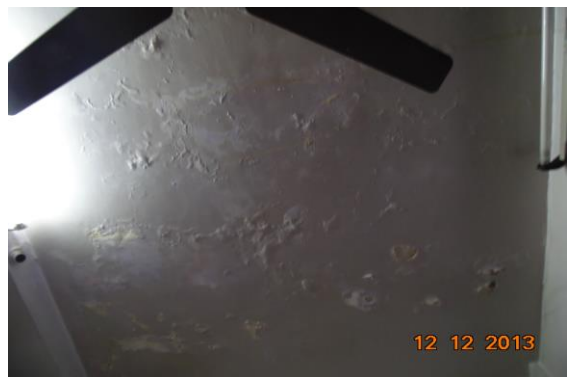
Photo 12

Dampness/Seepage on Roof of Shop No. 228 of Ground Floor

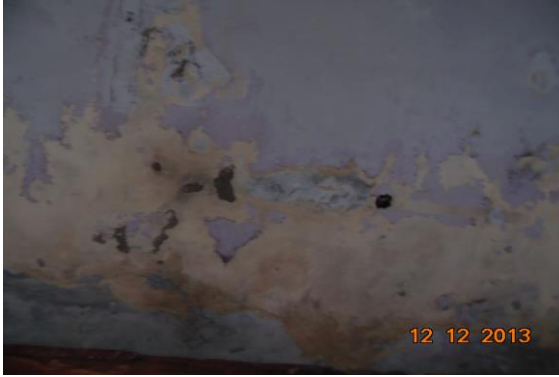
Photo 13

Dampness/Seepage on Roof of Varanda of Shop No. 228, Ground Floor

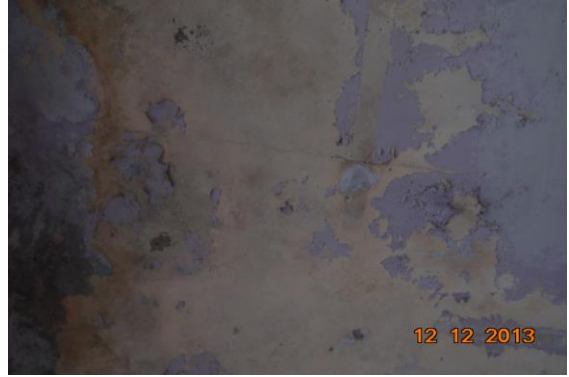
Photo 14

Plaster Crack on Roof of Varanda of Shop No. 228, Ground Floor

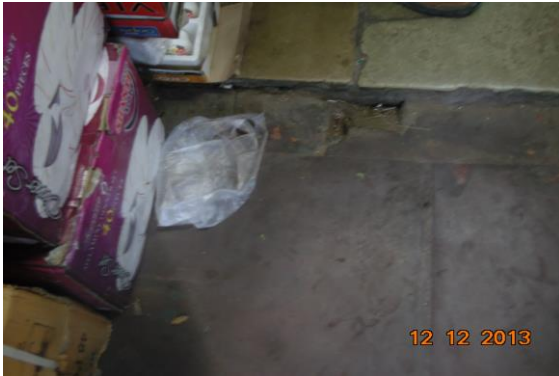
Photo 15

Damaged Portion on Floor of Varanda of Shop No. 227, Ground Floor

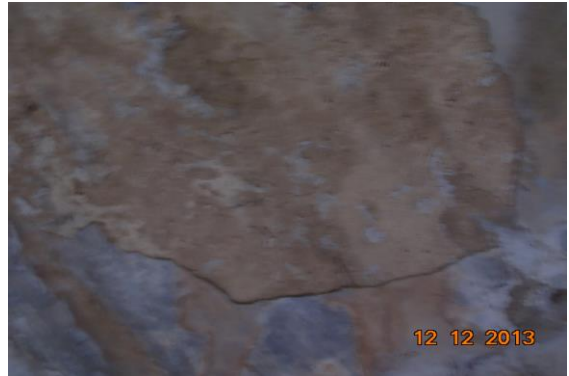
Photo 16

Dampness/Seepage on Roof of Varanda of Shop No. 227, Ground Floor

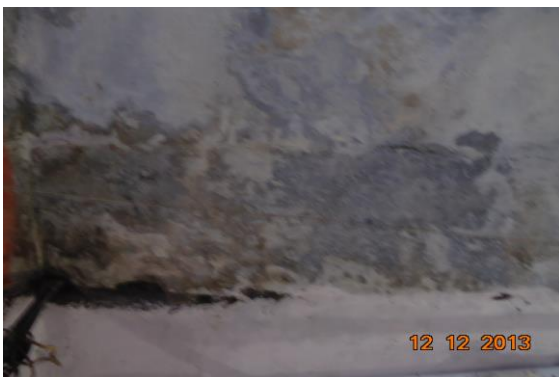
Photo 17

Dampness/Seepage on Roof of Varanda of Ground Floor

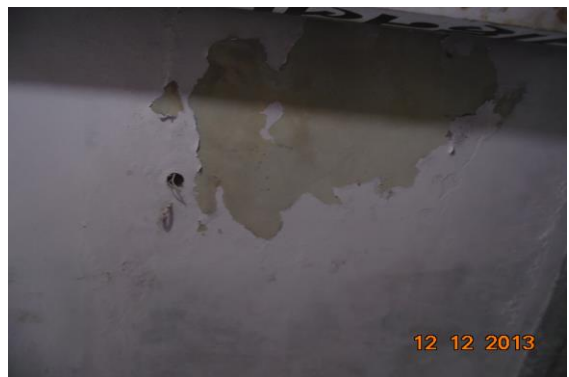
Photo 18

Dampness/Seepage on Roof of Varanda of Shop No. 226, Ground Floor

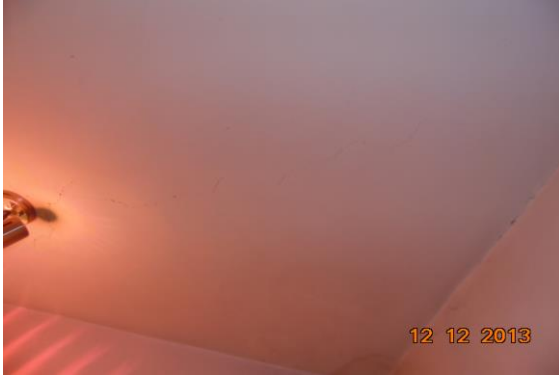
Photo 19

Peeling of Plaster on Roof of Shop No. 225 of Upper Ground Floor

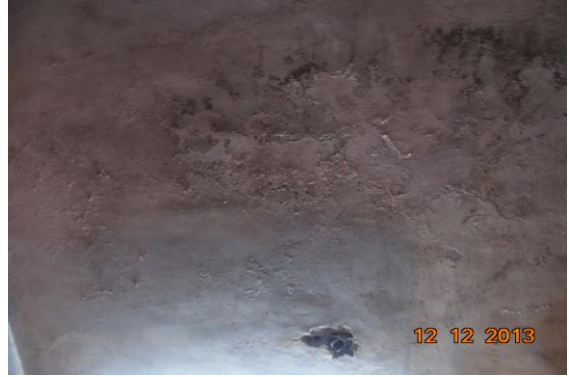
Photo 20

Dampness/Seepage on Roof of Varanda of Shop No. 225, Ground Floor

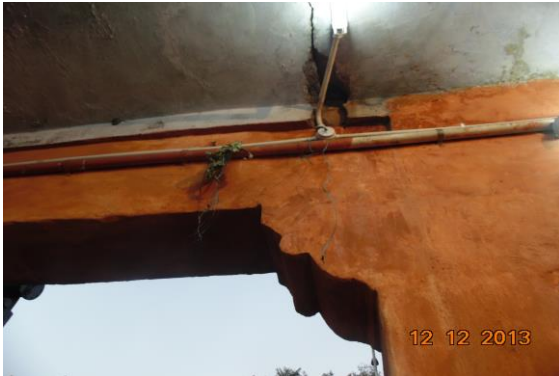
Photo 21

Damaged Portion on Roof of Varanda of Shop No. 225, Ground Floor

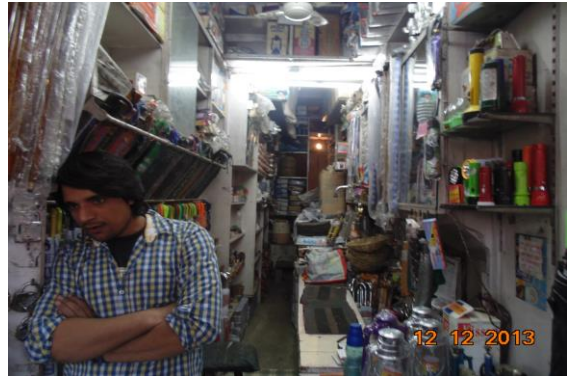
Photo 22

All Walls of Shop No. 229 of Ground Floor Covered With Material

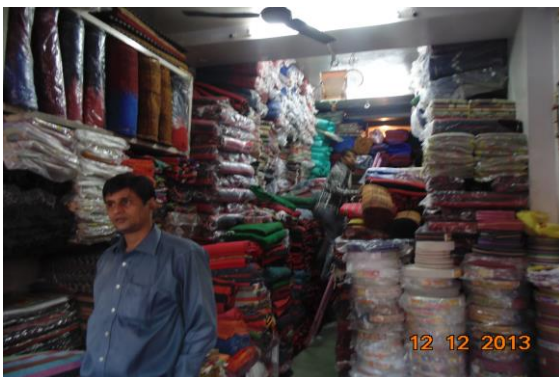
Photo 23

All Walls of Shop No. 228 of Ground Floor Covered With Material

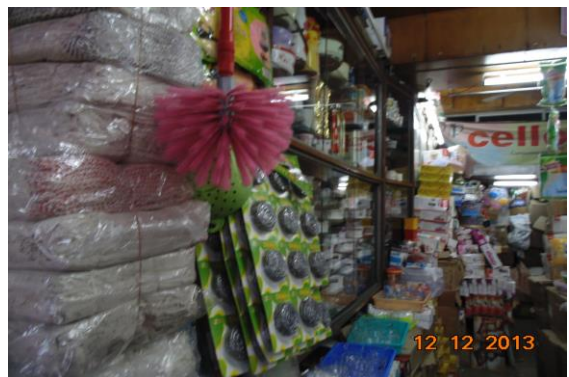
Photo 24

Wall No. 1 & 4 of Shop No. 227 of Ground Floor Covered With Material

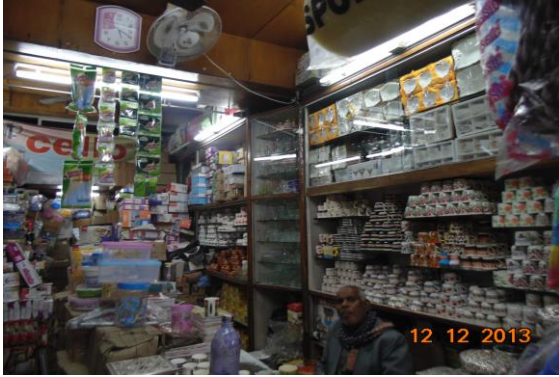
Photo 25

Wall No. 2 & 4 of Shop No. 227 of Ground Floor Covered With Material

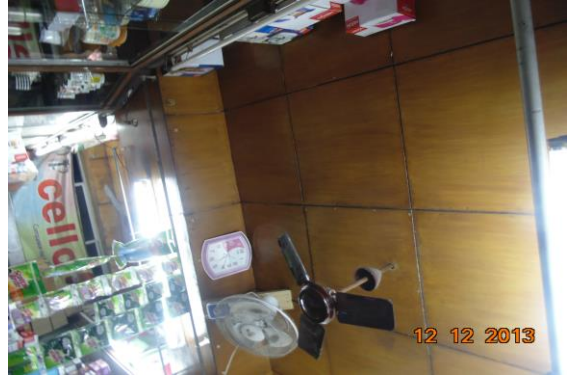
Photo 26

Roof of Shop No. 227 of Ground Floor Covered With Wooden Work

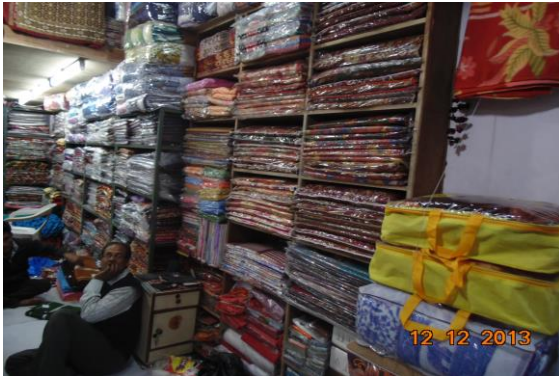
Photo 27

Wall No. 1 of Shop No. 226 of Ground Floor Covered With Material

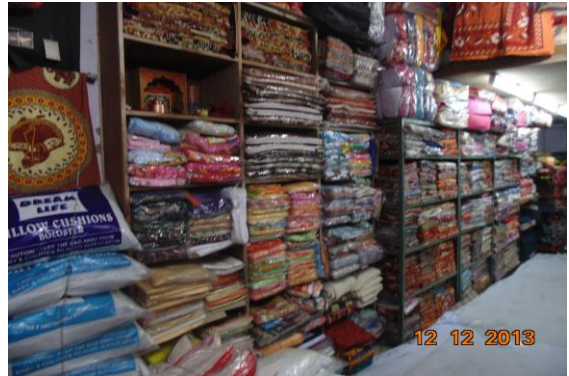
Photo 28

Wall No. 2 of Shop No. 226 of Ground Floor Covered With Material

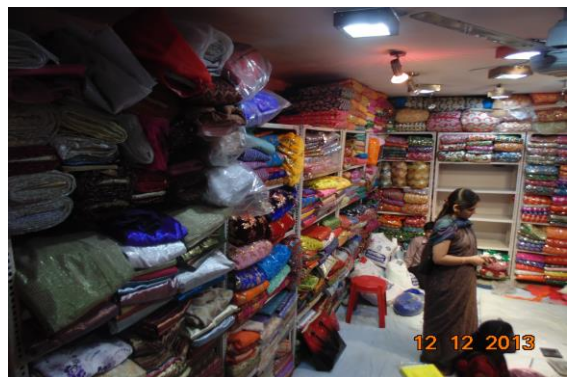
Photo 30

Wall No. 2 & 4 of Shop No. 225 of Ground Floor Partially Covered

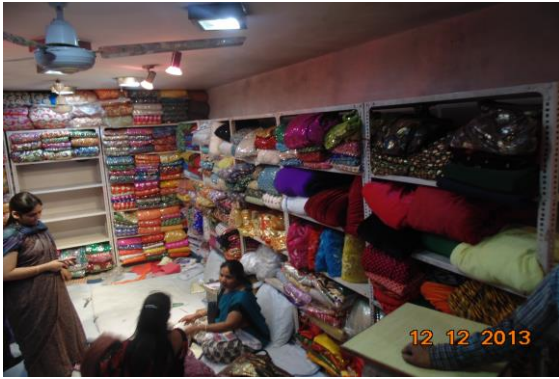
Photo 31

Wall No. 1 & 4 of Shop No. 225 of Ground Floor Partialy Covered

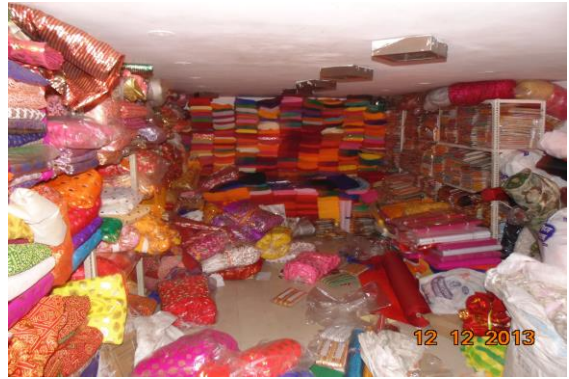
Photo 32

All Walls of Shop No. 225 of Upper Ground Floor Covered With Material

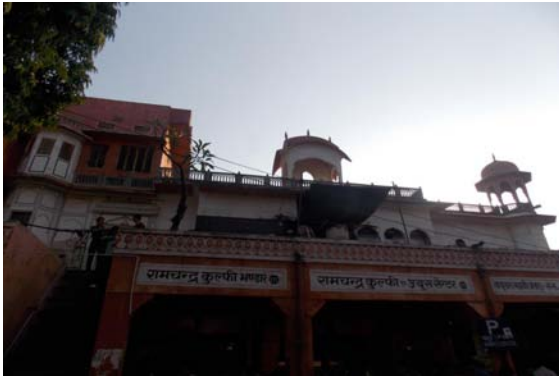
Photo 1
View of House No.429

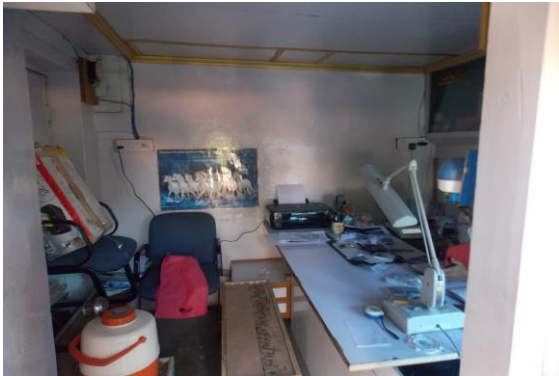
Photo 7
View of Shop no.2, First Floor

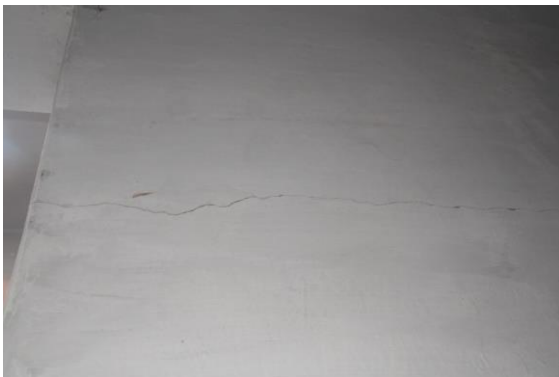
Photo 9
Horizontal Crack on Wall No. 2 of Passage No.2, First Floor, Approx.
Width = 1mm, Approx. Length = 2m.
Distance from Wall No.2 = 0.6m, Height from Floor = 2.3m.

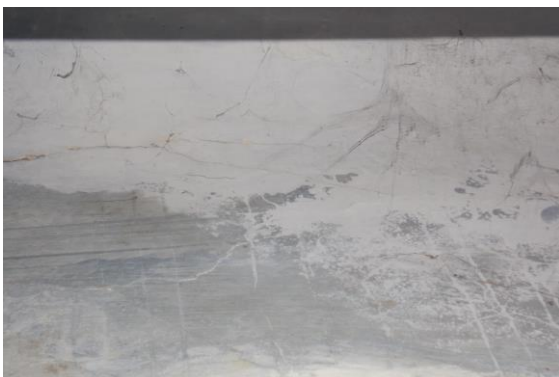
Photo 10
Inclined Crack on Wall No. 1 of Passage No.2, First Floor, Approx. Width = 2mm, Approx. Length = 2.1m.
Distance from Wall No.3 = 2m, Height from Floor = 2.6m.

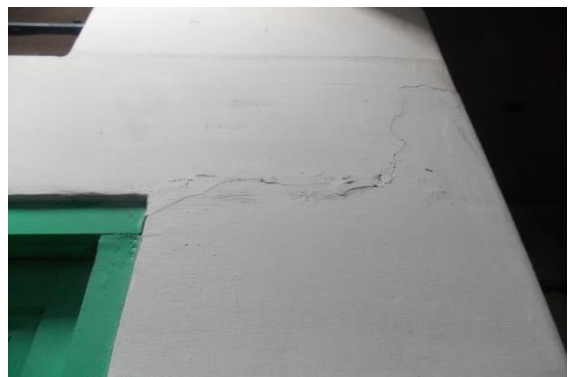
Photo 11
Inclined Crack on Wall No. 2 of Passage No.4, First Floor, Approx. Width = 0.3mm, Approx. Length = 0.8m.
Distance from Wall No.3 = 0.4m, Height from Floor = 2.1m.

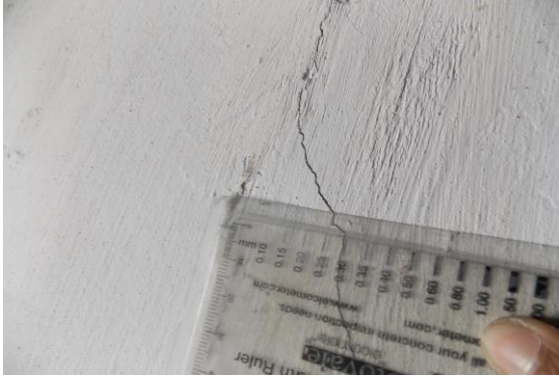
Photo 11A

Inclined Crack on Wall No. 2 of Passage No.4, First Floor, Approx. Width = 0.3mm, Approx. Length = 0.8m.
Distance from Wall No.3 = 0.4m, Height from Floor = 2.1m.

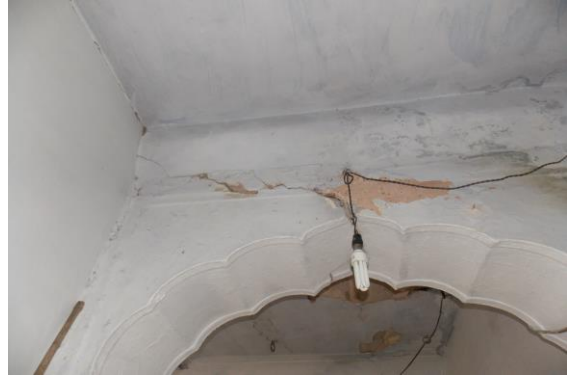
Photo 12

Horizontal Crack on Roof of Temple No.1, First Floor, Approx. Width = 1.5mm, Approx. Length = 2m.
Distance from Wall No.4 = 0.2m, Height from Floor = 3.2m.

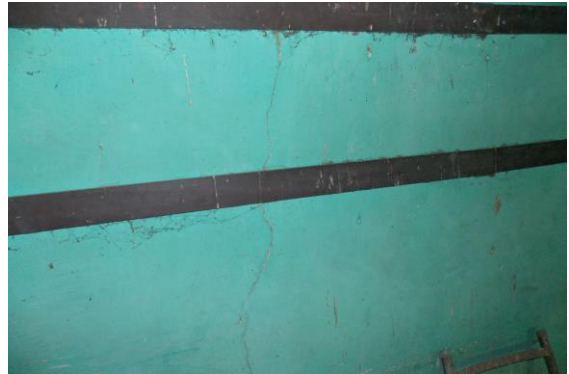
Photo 14

Inclined Crack on Wall No. 2 of House No.429, Approx. Width = 2mm, Approx. Length = 3m.
Distance from Wall No.3 = 2.4m, Height from Floor = 0m.

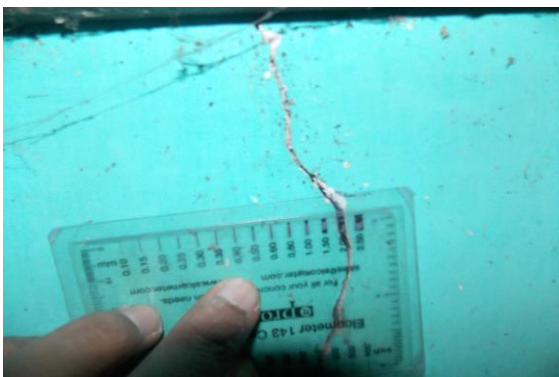
Photo 14A

Inclined Crack on Wall No. 2 of House No.429, Approx. Width = 2mm, Approx. Length = 3m.
Distance from Wall No.3 = 2.4m, Height from Floor = 0m.

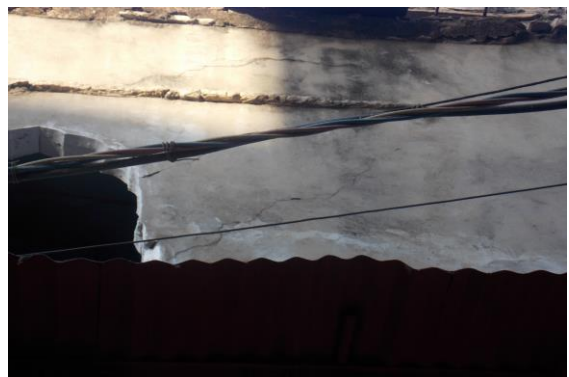
Photo 15

Inclined Crack on Backside Wall of House No.429, Approx. Width = 1mm, Approx. Length = 1.5m. Distance from Left Side external Column = 7m, Height from Floor = 6m.

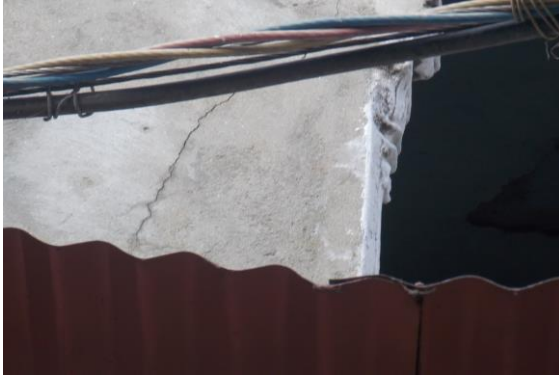
Photo 16

Inclined Crack on Wall No. Backside Wall of House No.429, Approx. Width = 1.8mm, Approx. Length = 1.3m. Distance from Left Side external Column = 5.5m, Height from Floor = 5.5m.

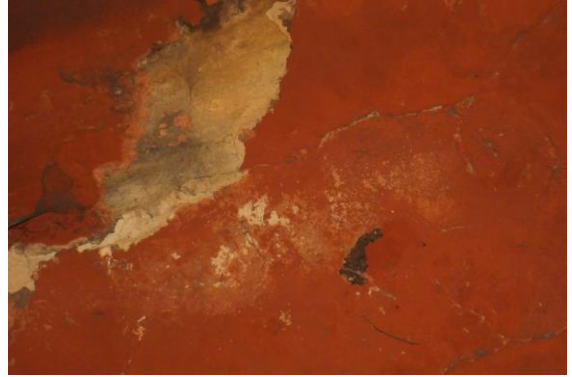
Photo 17

Peeling of Plaster on Roof of Varanda of Ground Floor

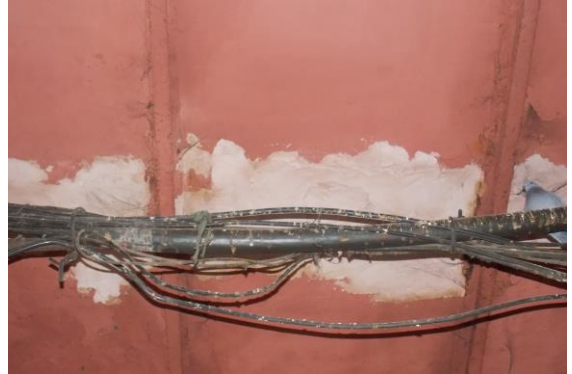
Photo 19

Peeling of Plaster on Roof of Varanda of Shop No. 2, Ground Floor

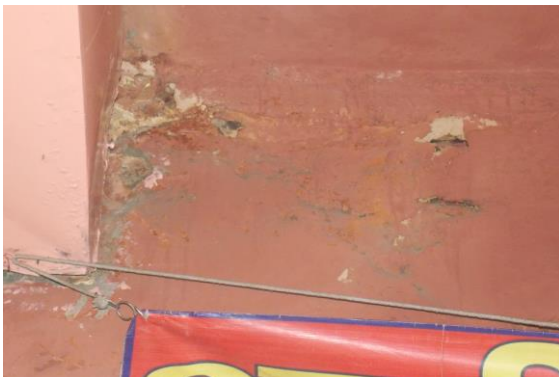
Photo 20

Peeling of Plaster on Beam of Varanda of Shop No. 2, Ground Floor

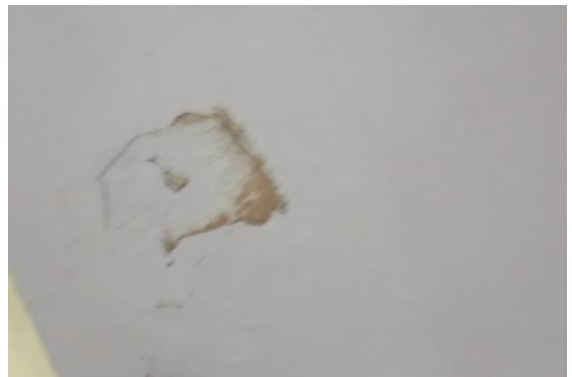
Photo 21

Peeling of Plaster on Roof of Shop No. 4 of Ground Floor

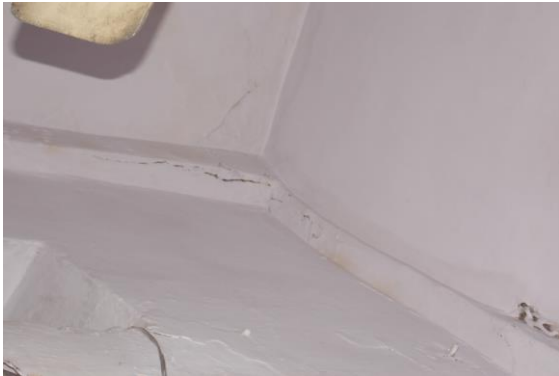
Photo 22
Peeling of Plaster on Roof of Shop No. 4 of Ground Floor

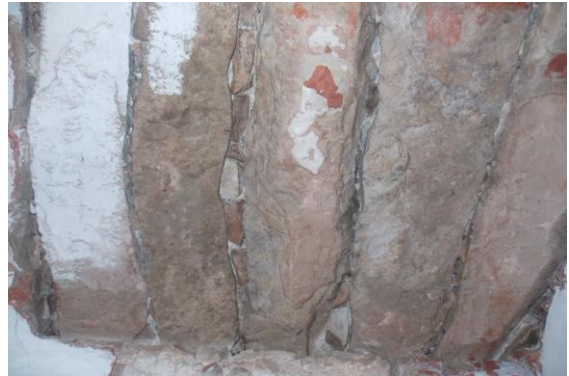
Photo 23
Damaged Portion on Roof of Passage No.1 of First Floor

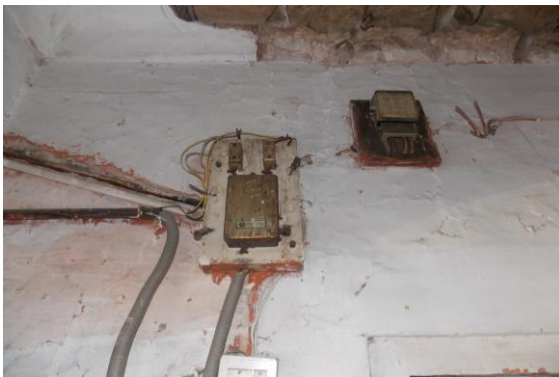
Photo 24
Peeling of Plaster on Wall No. 1 of Passage No.1 of First Floor

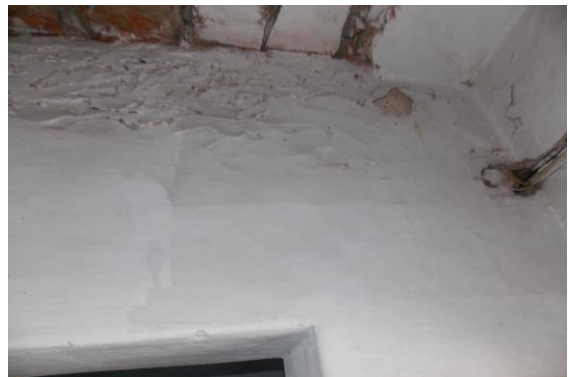
Photo 25
Peeling of Plaster on Wall No. 2 of Passage No.1 of First Floor

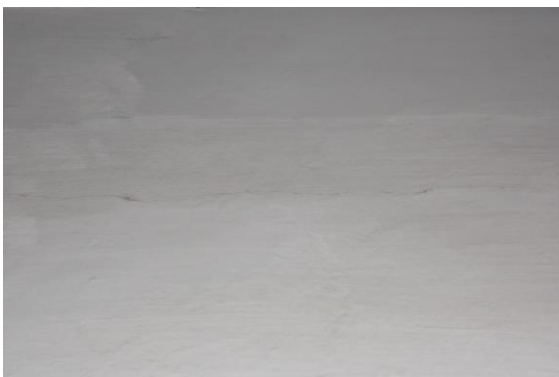
Photo 26
Plaster Crack on Wall No. 4 of Passage No.2 of First Floor

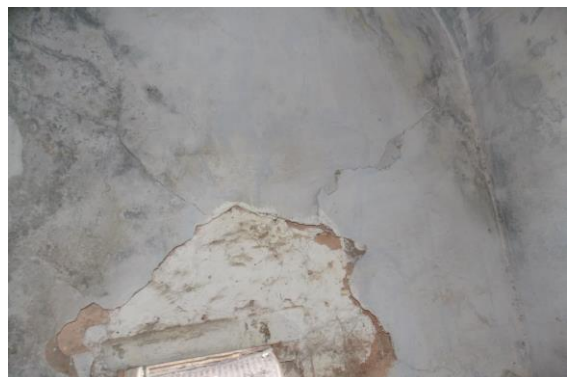
Photo 27
Peeling of Plaster on Wall No. 1 of Passage No.2 of First Floor

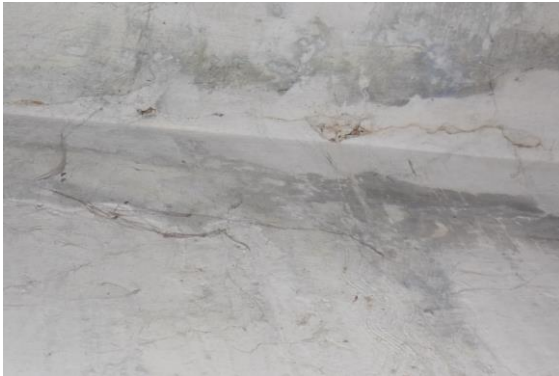
Photo 28
Peeling of Plaster on Roof & 3 of Passage No.2 of First Floor

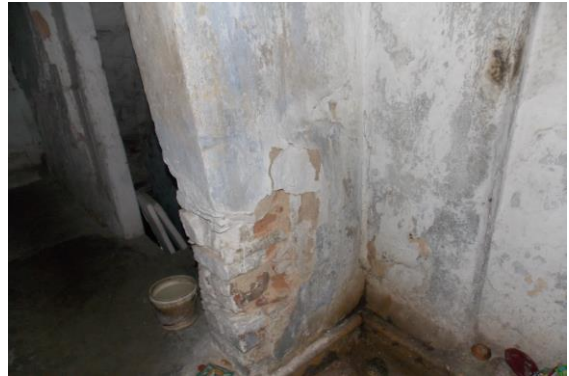
Photo 29
Peeling of Plaster on Wall No. 3 & 1 of Passage No.2 of First Floor

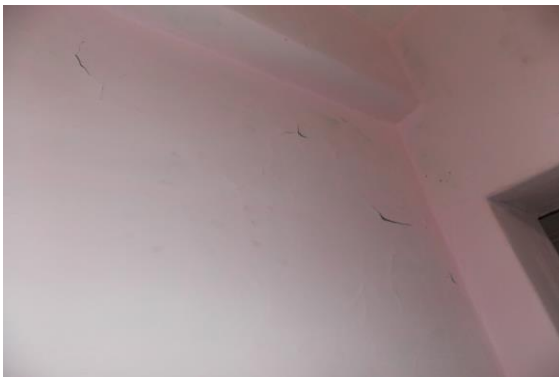
Photo 30
Peeling of Plaster on Wall No. 1 of Room No. 4 of First Floor

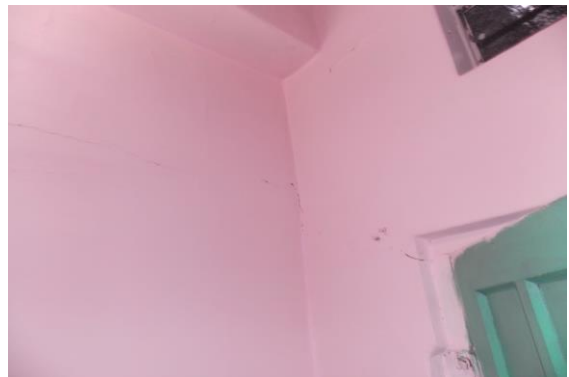
Photo 31
Peeling of Plaster on Wall No. 2 & 3 of Room No. 4 of First Floor

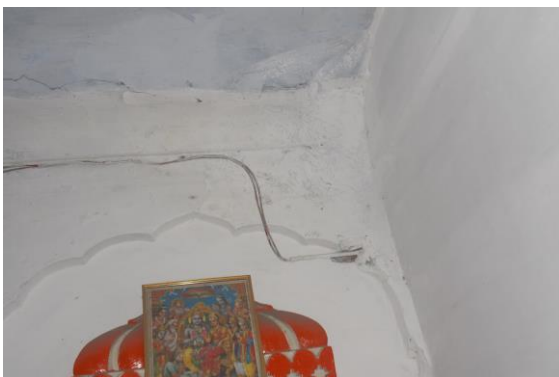
Photo 32
Peeling of Plaster on Wall No. 2 & 3 of Room No. 4 of First Floor

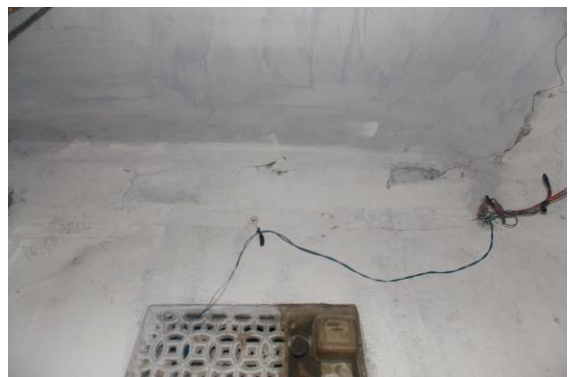
Photo 33
Dampness/Seepage on Wall No. 4 of Temple No.1 of First Floor

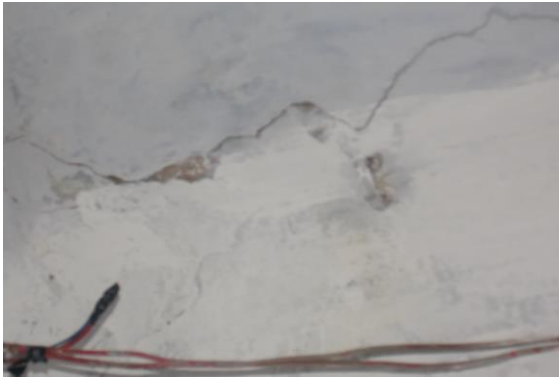
Photo 34
Dampness/Seepage on Wall No. 1 of Temple No.1 of First Floor

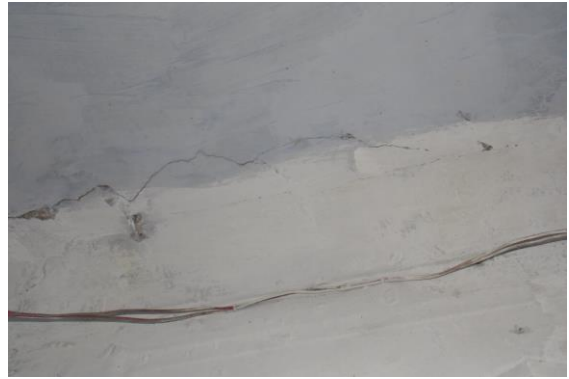
Photo 35
Damaged Portion on Roof of Temple No.1 of First Floor

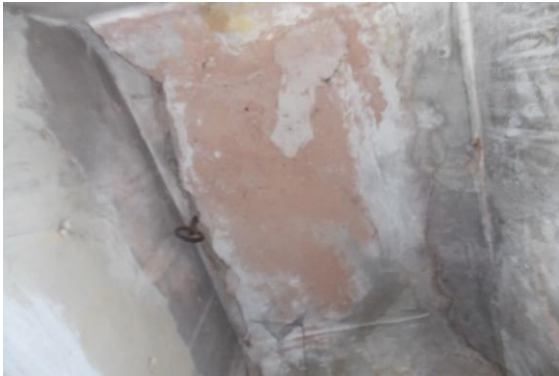
Photo 36
Damaged Portion on Roof of Passage No.3 of First Floor

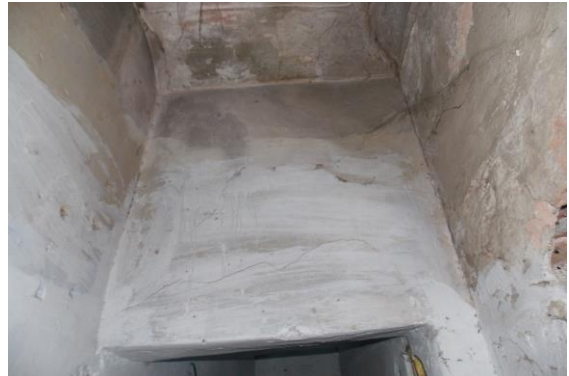
Photo 37
Damaged Portion on Wall No. 4 of Passage No.3 of First Floor

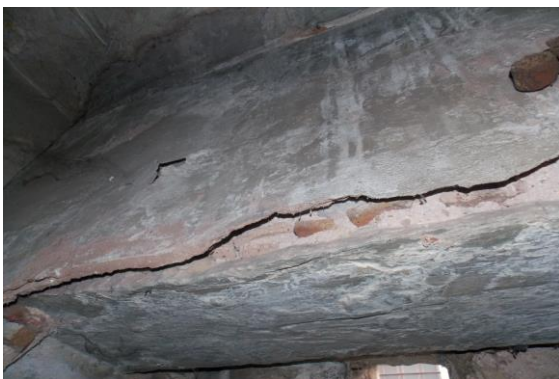
Photo 38
Damaged Portion on Wall No. 2 of Passage No.3 of First Floor

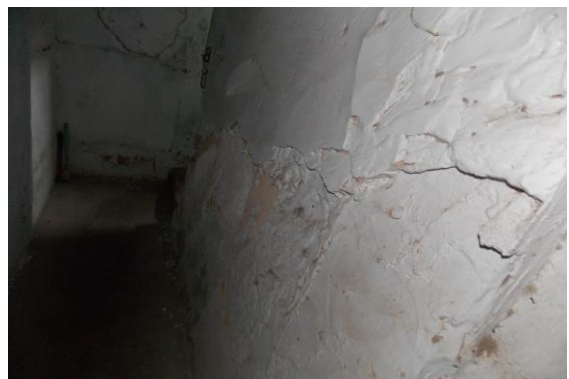
Photo 39
Damaged Portion on Wall No. 2 of Passage No.3 of First Floor

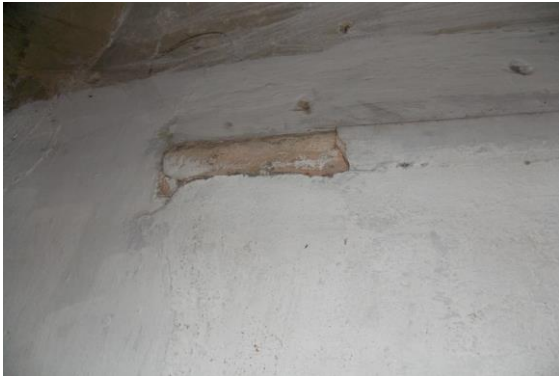
Photo 40
Peeling of Plaster on Wall No. 1 of Passage No.3 of First Floor

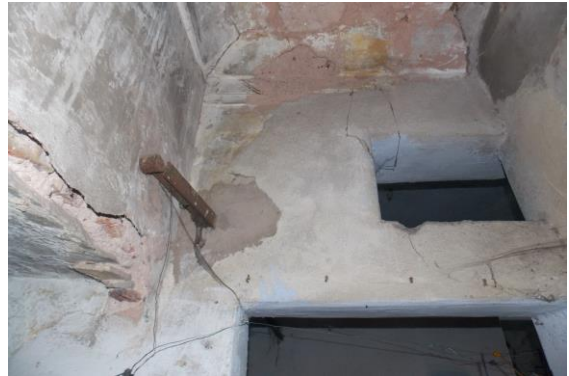
Photo 41
Peeling of Plaster on Wall No. 3 of Passage No.3 of First Floor

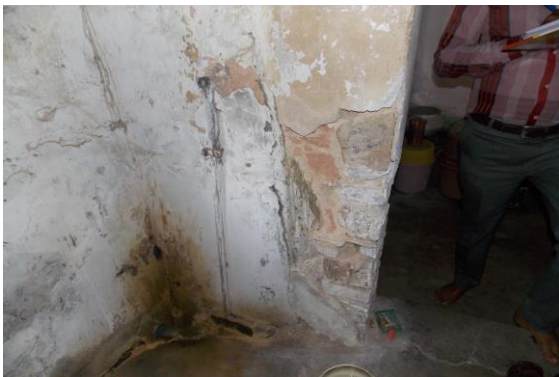
Photo 42
Peeling of Plaster on Wall No. 3 of Passage No.3 of First Floor

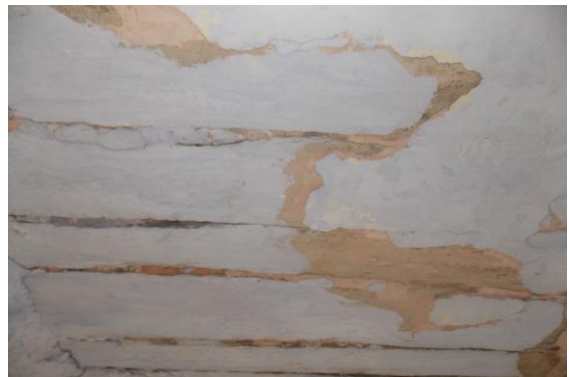
Photo 43
Damaged Portion on Roof of Lobby No.1 of First Floor

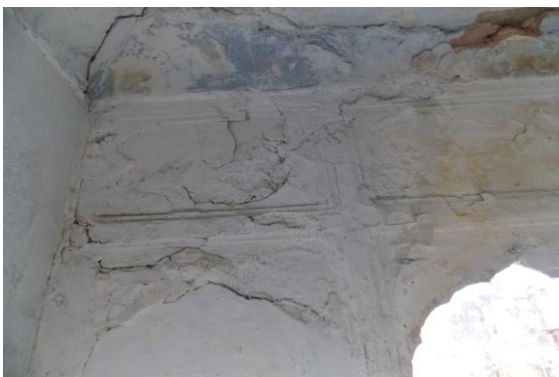
Photo 44
Peeling of Plaster on Wall No. 1 of Lobby No.1 of First Floor

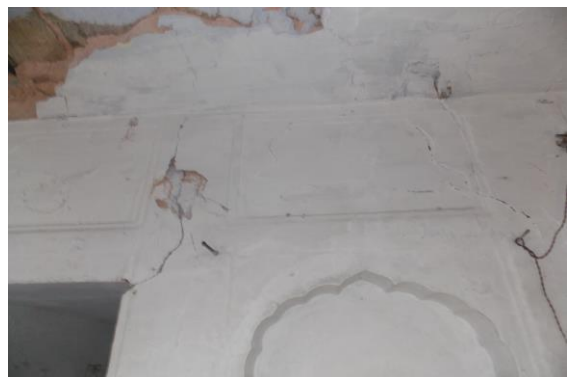
Photo 45
Peeling of Plaster on Wall No. 4 of Lobby No.1 of First Floor

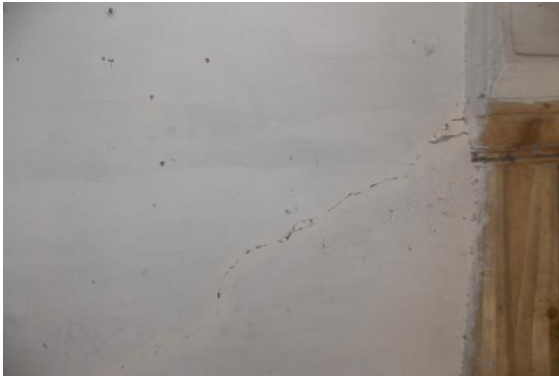
Photo 46
Peeling of Plaster on Wall No. 2 of Lobby No.1 of First Floor

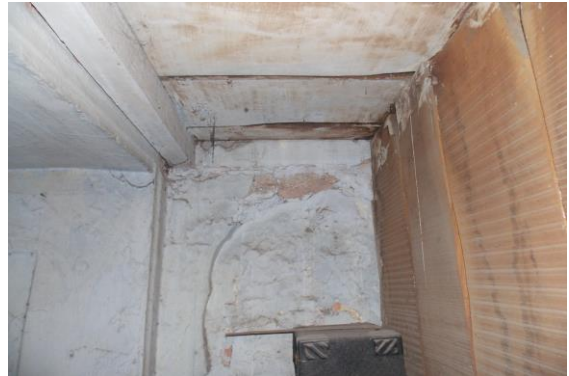
Photo 47
Peeling of Plaster on Wall No. 4 of Passage No.5 of First Floor

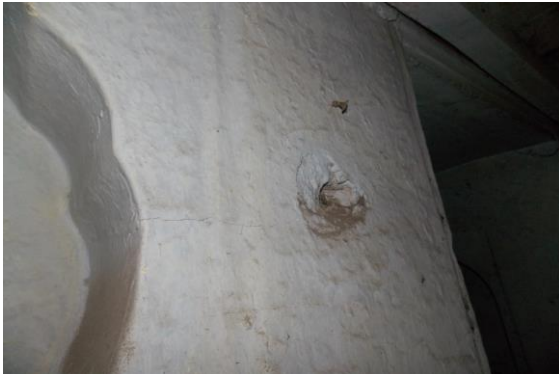
Photo 48
Peeling of Plaster on Wall No. 2 of Passage No.5 of First Floor

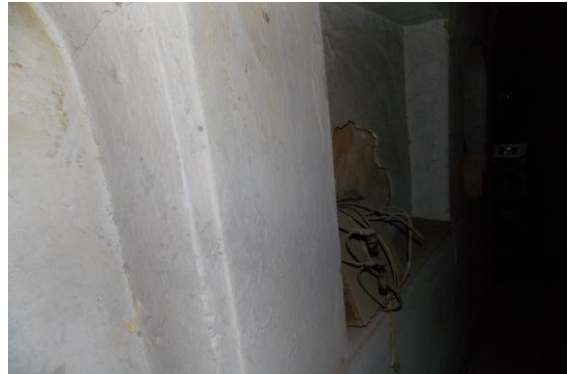
Photo 49
Damaged Portion on Wall No. 1 of Passage No.8 of First Floor

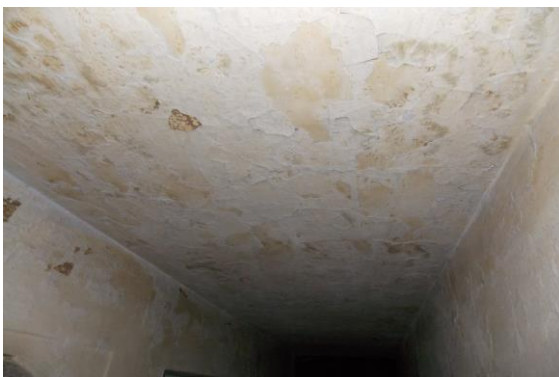
Photo 50
Dampness/Seepage on Roof of Passage No.8 of First Floor

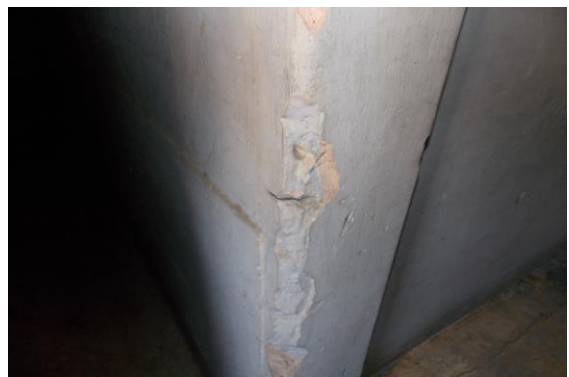
Photo 51
Peeling of Plaster on Wall No. 2 of Passage No.8 of First Floor

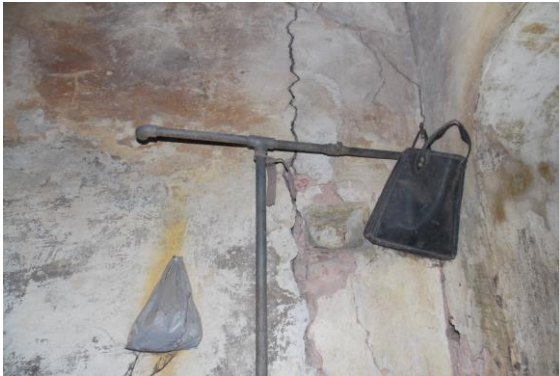
Photo 52

Damaged Portion on Wall No. 4 of Room No. 5 of First Floor

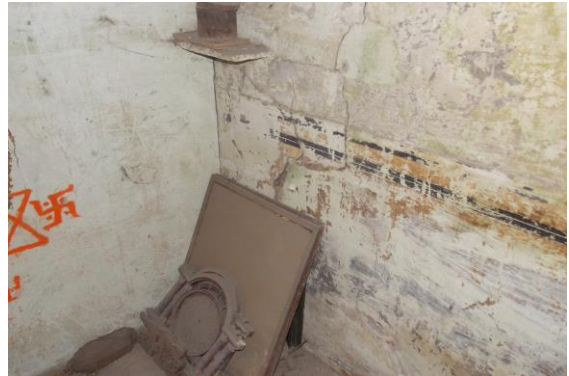
Photo 53

Damaged Portion on Wall No. 4 of Room No. 5 of First Floor

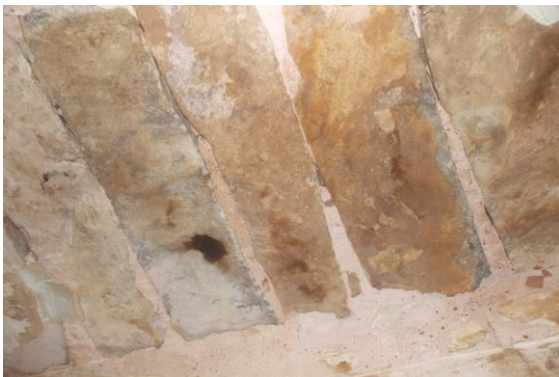
Photo 54

Damaged Portion on Roof of Room No. 5 of First Floor

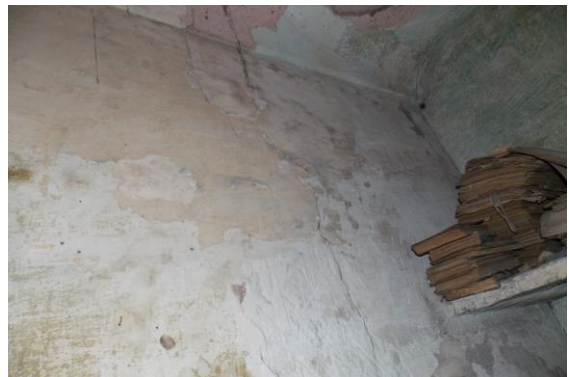
Photo 55

Damaged Portion on Wall No. 3 of Room No. 5 of First Floor

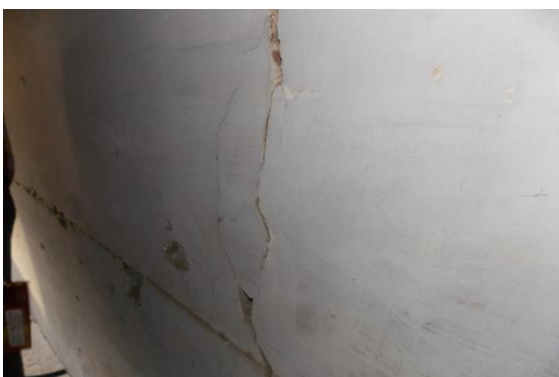
Photo 56

Damaged Portion on Wall No. 1 of Passage No.7 of First Floor

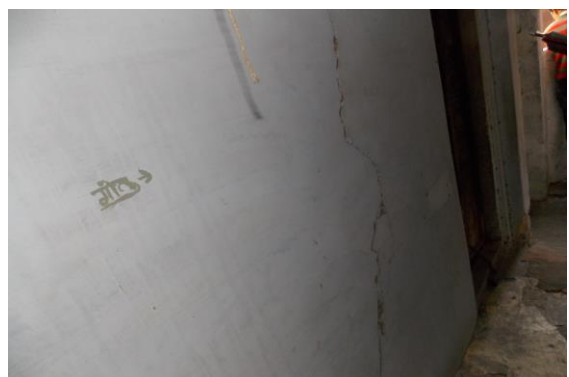
Photo 57

Damaged Portion on Wall No. 2 of Passage No.7 of First Floor

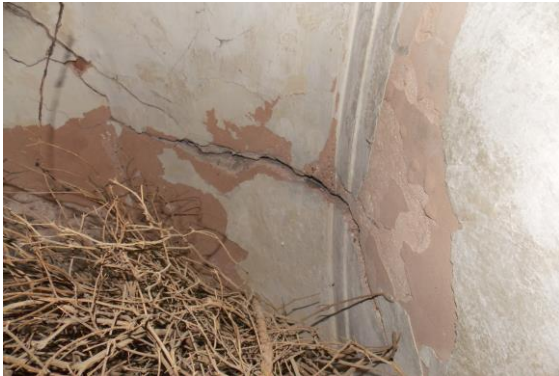
Photo 58

Damaged Portion on Roof of Passage No.7 of First Floor

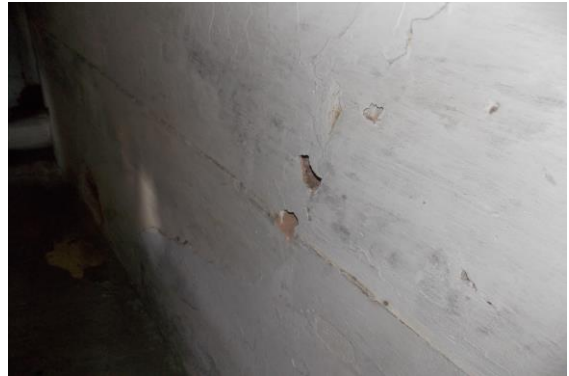
Photo 59

Peeling of Plaster on Wall No. 2 of Passage No.6 of First Floor

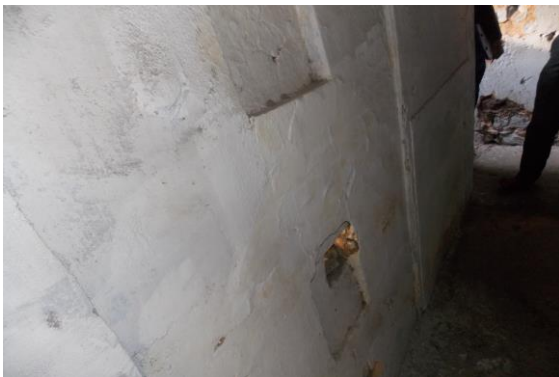
Photo 60

Peeling of Plaster on Wall No. 1 of Passage No.6 of First Floor

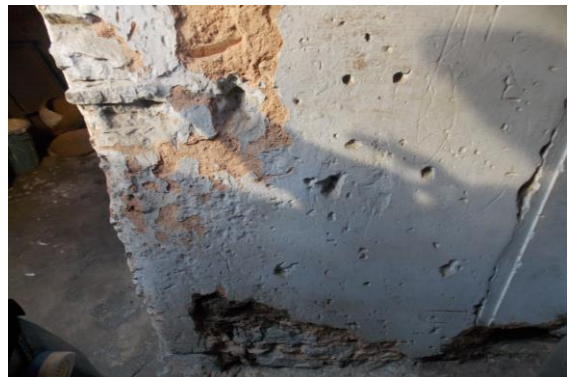
Photo 61

Peeling of Plaster on Wall No. 4 of Passage No.6 of First Floor

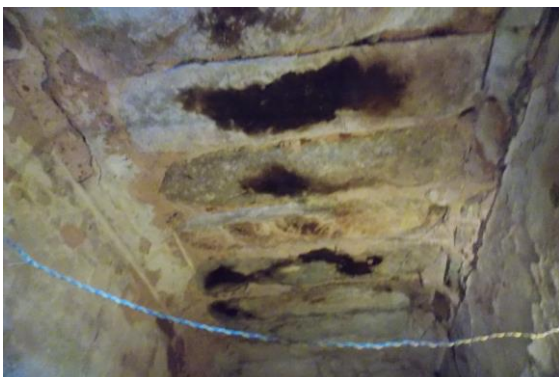
Photo 62

Dampness/Seepage on Roof of Room No. 6 of First Floor

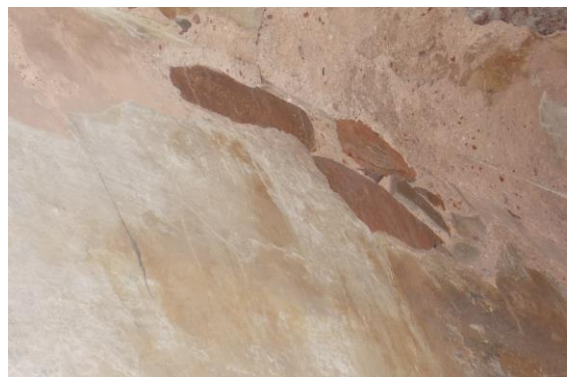
Photo 63

Damaged Portion on Wall No. 1 of Room No. 6 of First Floor

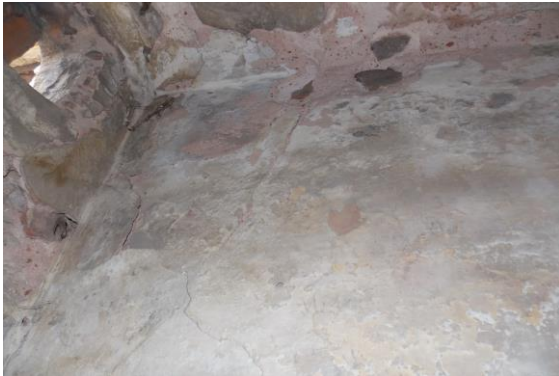
Photo 64

Damaged Portion on Wall No. 1 of Room No. 6 of First Floor

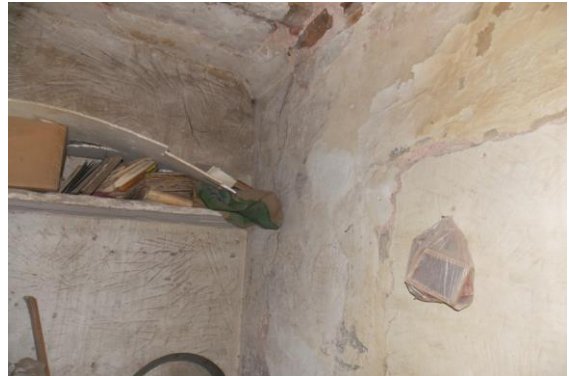
Photo 65

Damaged Portion on Wall No. 2 of Room No. 6 of First Floor

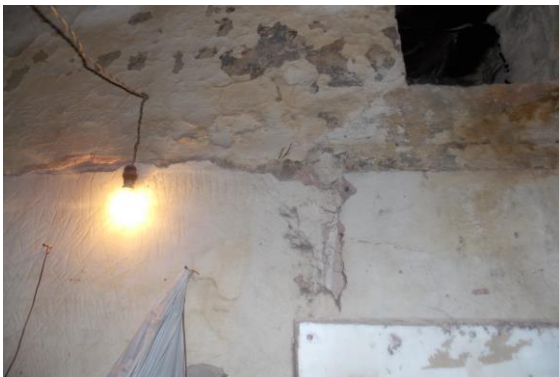
Photo 66

Damaged Portion on Wall No. 2 of Room No. 6 of First Floor

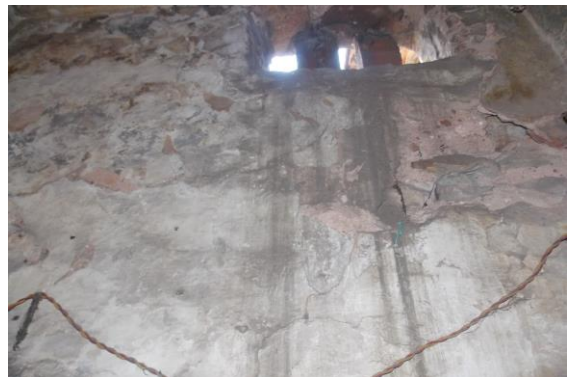
Photo 67

Damaged Portion on Wall No. 3 of Room No. 6 of First Floor

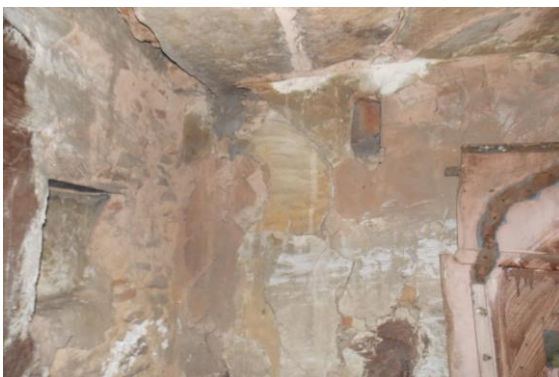
Photo 68

Damaged Portion on All wall & Roof of Lobby No.2 of First Floor

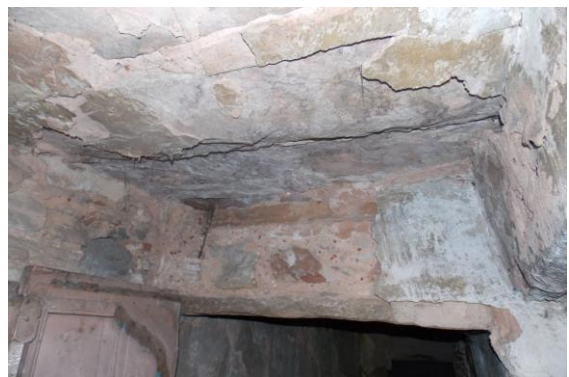
Photo 69

Damaged Portion on All wall & Roof of Lobby No.2 of First Floor

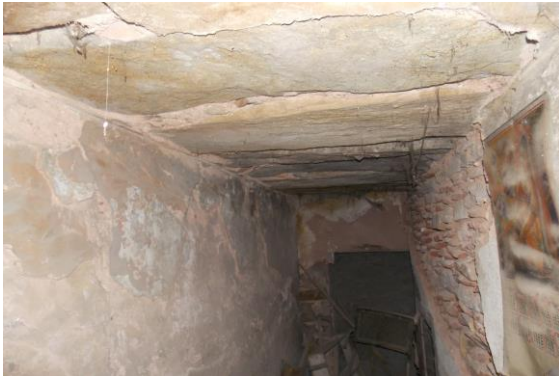
Photo 70

Damaged Portion on All wall & Roof of Store of First Floor

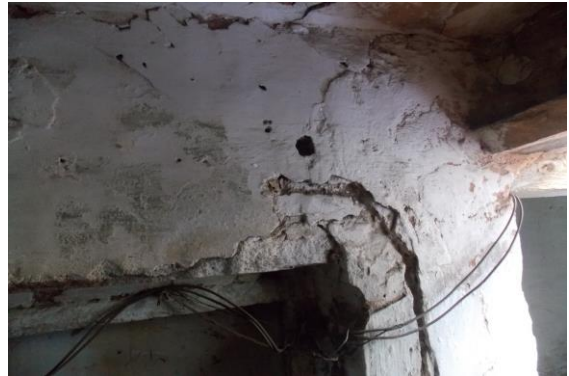
Photo 71

Damaged Portion on Roof of Store of First Floor

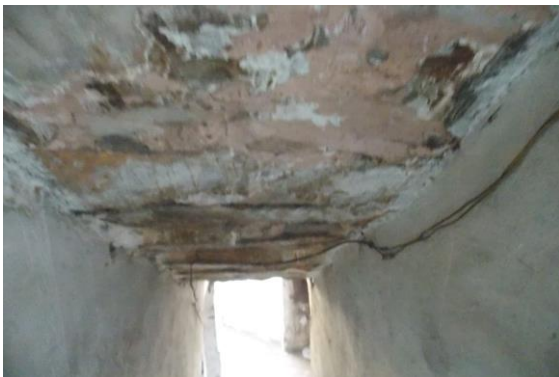
Photo 72

Damaged Portion on Wall No. 1 of Passage of

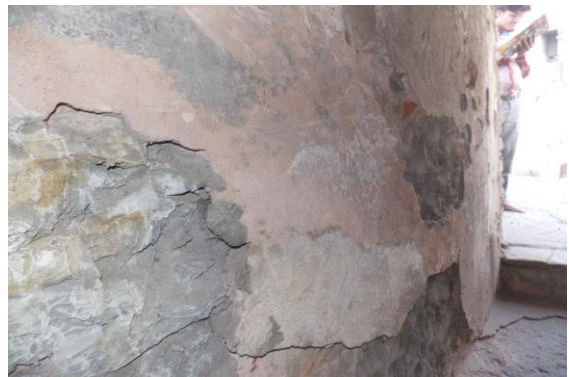
Photo 73

Damaged Portion on Wall No. 2 of Passage of

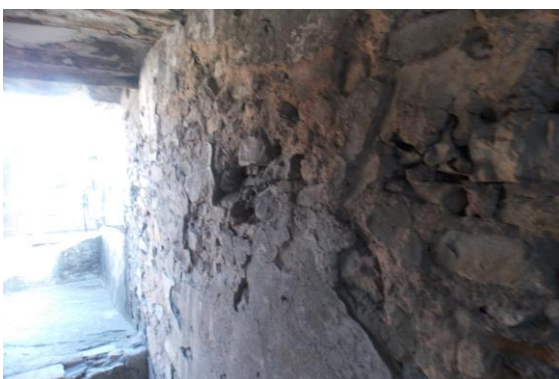
Photo 74

Damaged Portion on Roof of Passage of

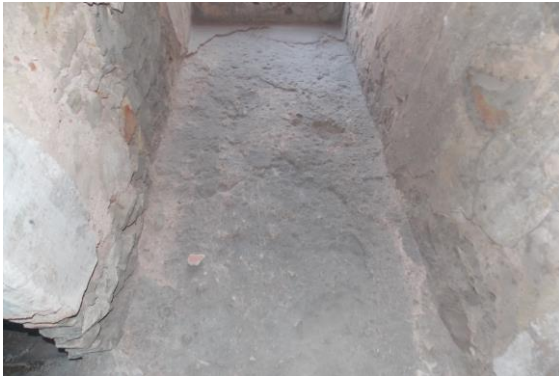
Photo 76
Damaged Portion of House No.429 of Terrace

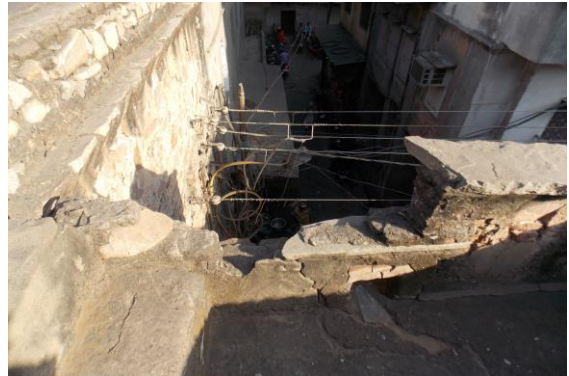
Photo 77
Damaged Portion of House No.429 of Terrace

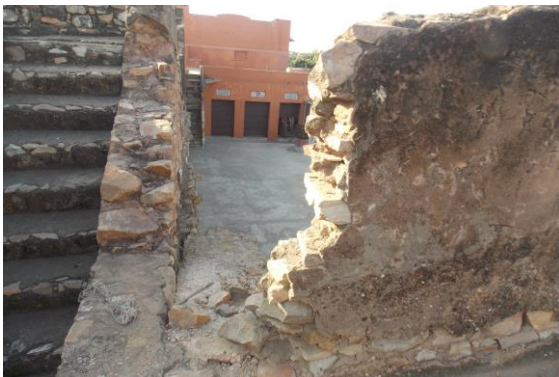
Photo 78
Damaged Portion of House No.429 of Terrace

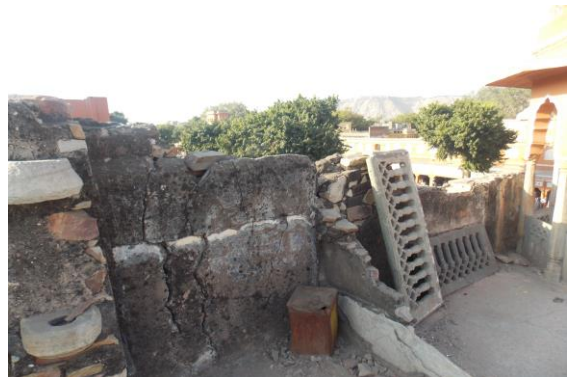
Photo 79
Damaged Portion of House No.429 of Terrace

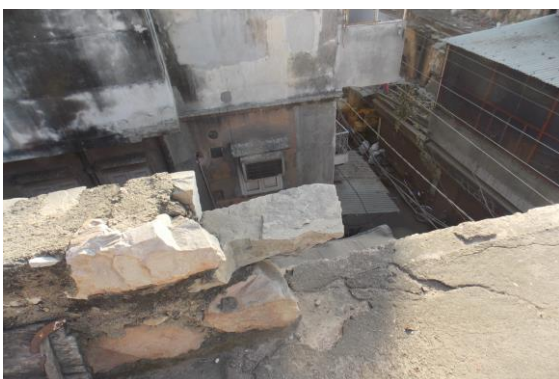
Photo 80
Damaged Portion of House No.429 of Terrace

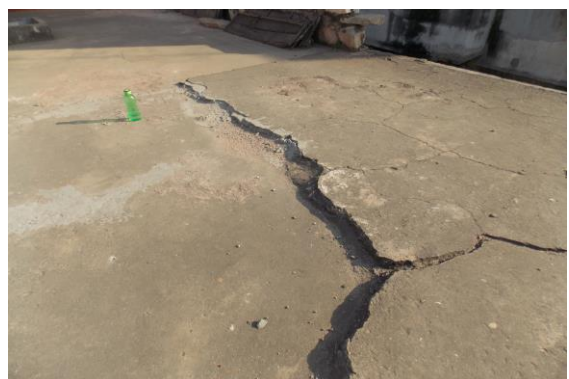
Photo 81
Damaged Portion on Floor of House No.429 of Terrace

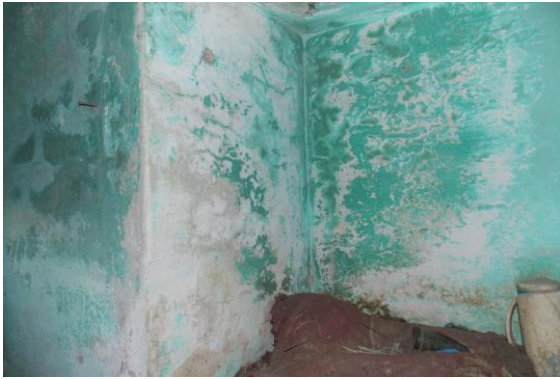
Photo 82

Dampness/Seepage on Wall No. 2 of Bathroom No. of House No.429

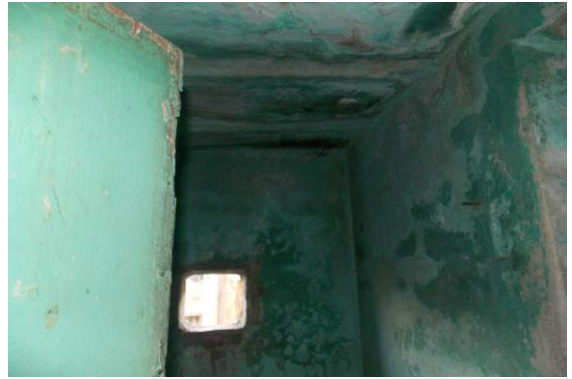
Photo 83

Dampness/Seepage on Wall No. 4 of Bathroom No. of House No.429

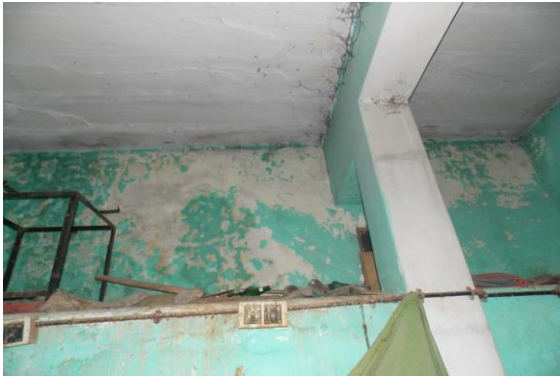
Photo 84

Dampness/Seepage on Wall No. 3 of Room No. 2 of House No.429
