Pre Building Condition Survey Report

Name and Address of Structure :	Choti Chopar to Badi Chopar (Down Line)
---------------------------------	---

Name of the Project	Contract JMRC-UG1B “Design and Construction of Tunnel between Chandpole and Badi Chouper and reverse line by Shield TBM, Underground Metro Stations at Choti Chouper and Badi Chouper by Cut and Cover Methods on East West Corridor of Jaipur Metro Rail Corporation Limited .”	
Owner :

Pre Building Condition Survey Report Choti Chopar to Badi Chopar (Down Line)

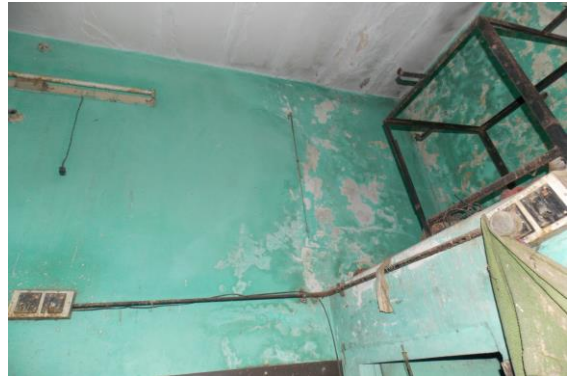
Photo 85

Dampness/Seepage on Wall No. 2 of Room No. 2 of House No.429

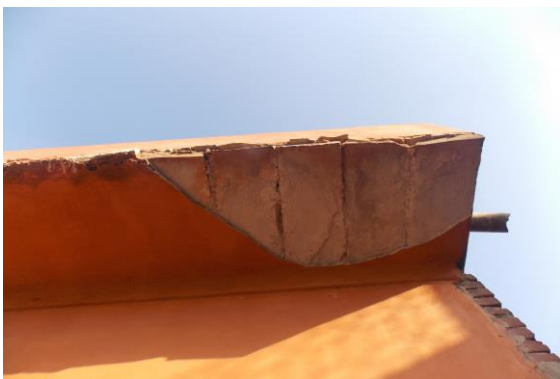
Photo 86

Peeling of Plaster on Sun Shade of Room No. 2 of House No.429

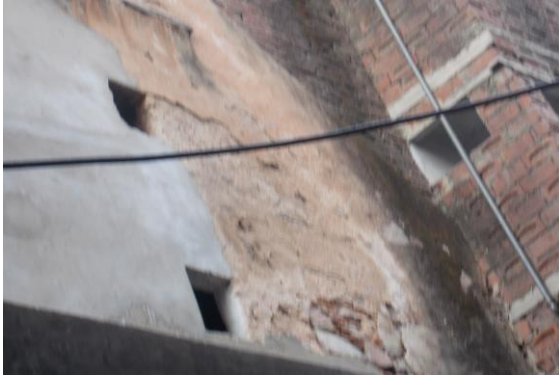
Photo 88
Damaged Portion on Backside Wall of House No.429 of

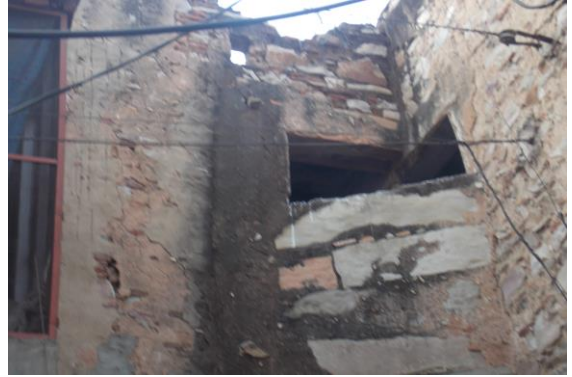
Photo 89
Damaged Portion on Backside Wall of House No.429 of

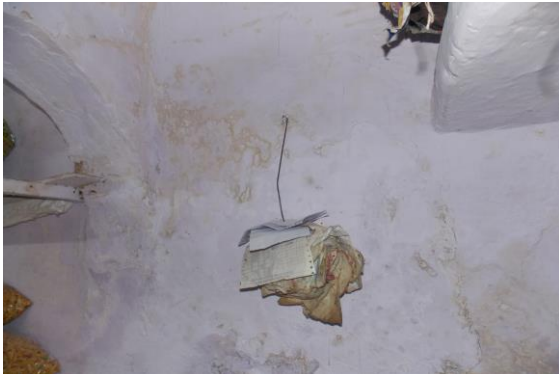
Summary of Defects Other Than Crack			
Defect ID	Location	Description	Photo No.
1	Shop No. 474 Part B Ground Floor	Dampness/Seepage	3
2	Shop No. 474 Part B Ground Floor	Damaged Portion	4
3	Roof Shop No. 474 Part B Ground Floor	Peeling of Plaster	5
4	Roof Shop No. 474 Part B Ground Floor	Dampness/Seepage	6
5	Roof Shop No. 474 Part B Ground Floor	Dampness/Seepage	7

Photo 3
Dampness/Seepage on Shop No. 474 Part B of Ground Floor

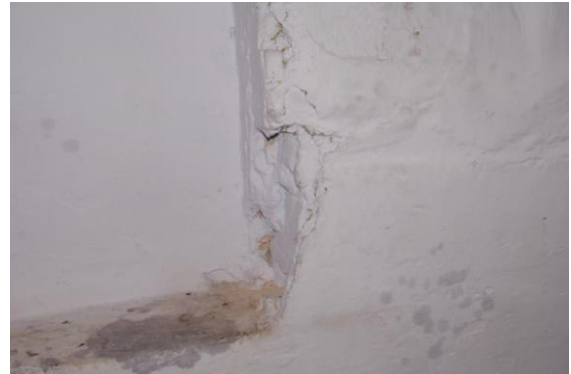
Photo 4
Damaged Portion on Shop No. 474 Part B of Ground Floor

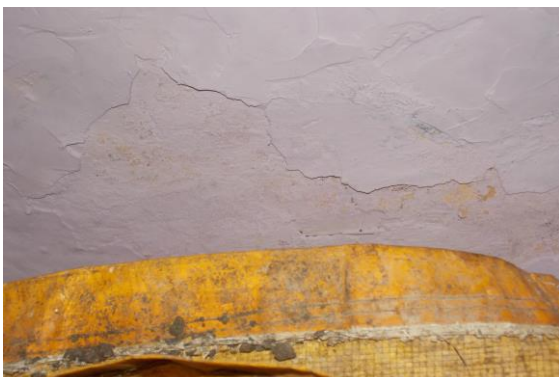
Photo 5
Peeling of Plaster on Roof of Shop No. 474 Part B of Ground Floor

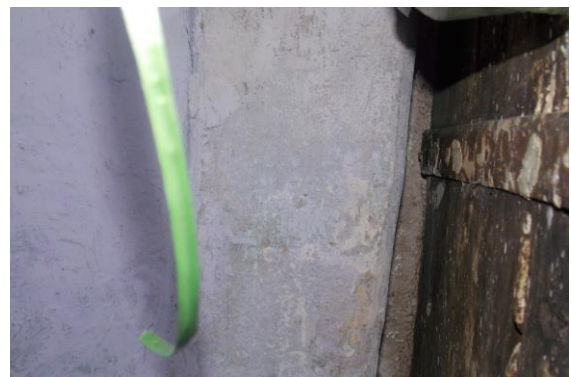
Photo 6
Dampness/Seepage on Roof of Shop No. 474 Part B of Ground Floor

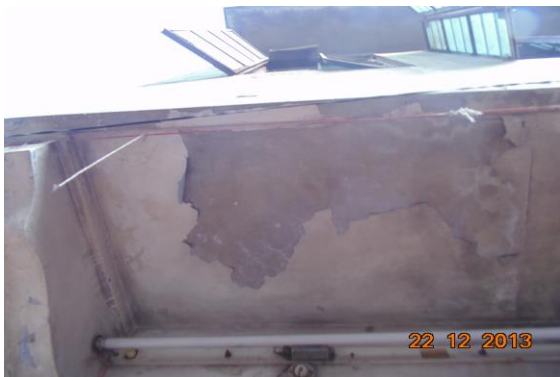
Summary of Cracks						
Defect ID	Location	Orientation	Appx. Width (mm)	Appx. Length (m)	Category	Photo No.
1	Outer Wall External Façade H. No.476 First Floor	Inclined	0.6	1.2	Very Slight	9
2	Outer Wall External Façade H. No.476 First Floor	Inclined	0.8	1	Very Slight	10

Photo 9
Inclined Crack on Wall No. of External Façade H. No.476, First Floor
Approx. Width = 0.6mm, Approx. Length = 1.2m. Distance from Leftside Wall = 1.5m, Height from Floor = 3m.

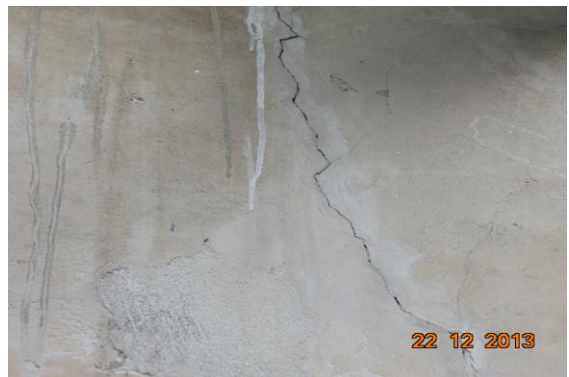
Photo 10
Inclined Crack on Outer Wall of External Façade H. No.476, First Floor
Approx. Width = 0.8mm, Approx. Length = 1m. Distance from Leftside Wall = 0.1m, Height from Floor = 3m.

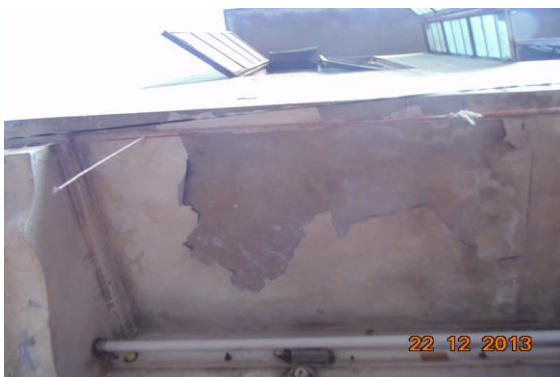
Summary of Defects Other Than Crack			
Defect ID	Location	Description	Photo No.
3	Roof Shade Temple Ground Floor	Peeling of Plaster	11
4	Roof Room No. 2 First Floor	Dampness/Seepage	12
5	Outer Wall External Façade H. No.476 Second Floor	Peeling of Plaster	13
6	Outer Wall External Façade H. No.476 First Floor	Dampness/Seepage	14

Photo 11
Peeling of Plaster on Roof Shade of Temple of Ground Floor

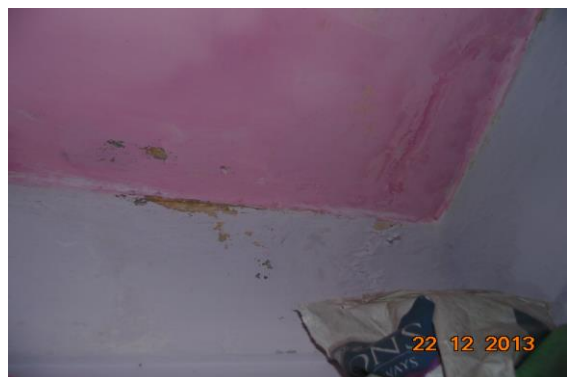
Photo 12
Dampness/Seepage on Roof of Room No. 2 of First Floor

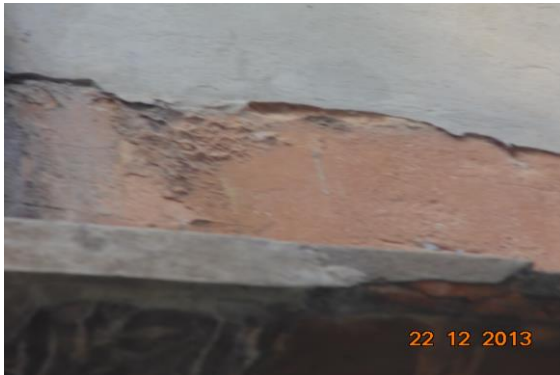
Photo 13
Peeling of Plaster on Outer Wall of External Façade H. No.476 of Second Floor

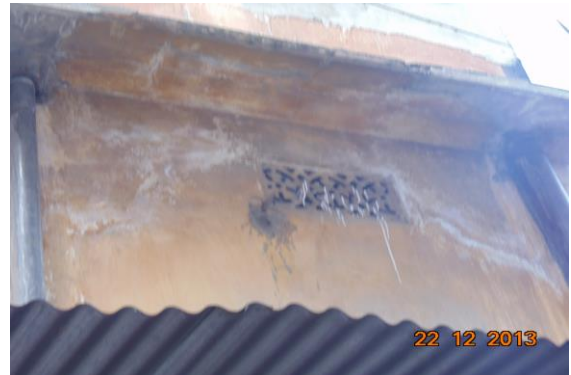
Photo 14
Dampness/Seepage on Outer Wall of External Façade H. No.476 of First Floor

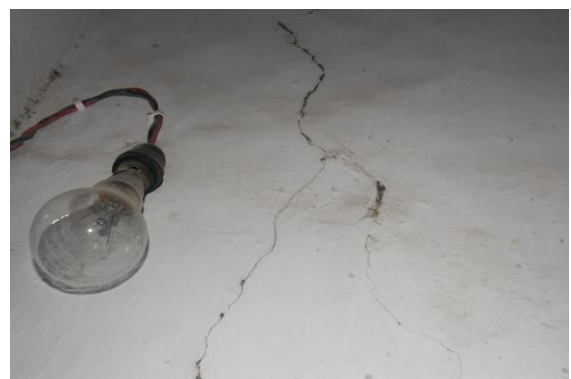
Summary of Cracks						
Defect ID	Location	Orientation	Appx. Width (mm)	Appx. Length (m)	Category	Photo No.
1	Stair Case GF to FF Ground Floor	Inclined	0.4	1.7	Very Slight	6, 6A
2	Room No. 3 First Floor	Inclined	0.2	1.4	Very Slight	7
3	Roof Room No. 3 First Floor	Horizontal	0.5	2.2	Very Slight	8
4	Roof & Wall No. 4 Room No. 4 First Floor	Inclined	0.6	1.3	Very Slight	9, 9A
5	Room No. 4 First Floor	Vertical	2	2.5	Slight	10
6	Roof House No. 478, Stair FF to SF	Inclined	1.5	3	Slight	11, 11A

Photo 6
Inclined Crack on Stair Case GF to FF, Ground Floor, Approx. Width = 0.4mm, Approx. Length = 1.7m.
Distance from W2 = 0.4m, Height from Floor = 1m.

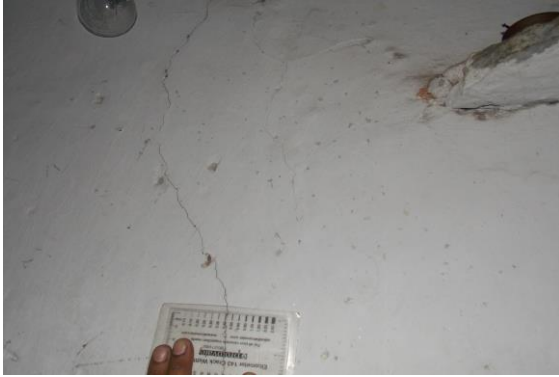
Photo 6A

Inclined Crack on Stair Case GF to FF, Ground Floor, Approx. Width = 0.4mm, Approx. Length = 1.7m.
Distance from W2 = 0.4m, Height from Floor = 1m.

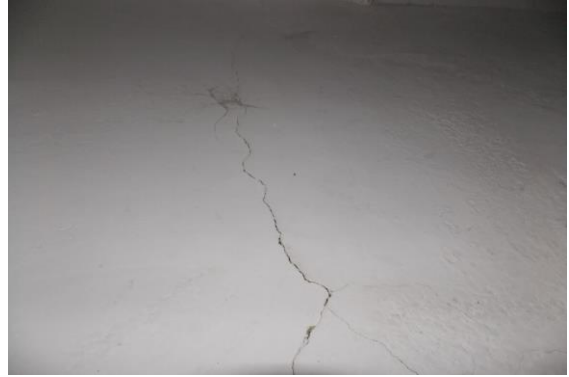
Photo 7

Inclined Crack on Room No. 3, First Floor, Approx. Width = 0.2mm, Approx. Length = 1.4m.
Distance from W2 = 1m, Height from Floor = 2.1m.

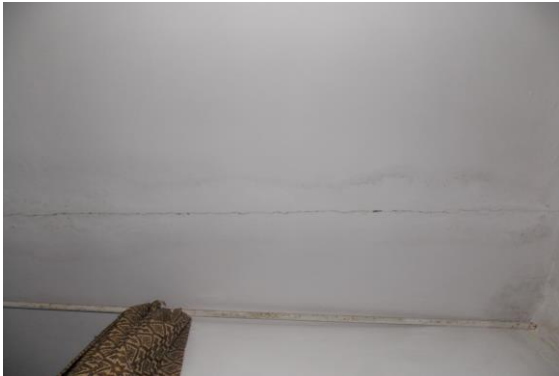
Photo 8

Horizontal Crack on Roof of Room No. 3, First Floor, Approx. Width = 0.5mm, Approx. Length = 2.2m.
Distance from W2 = 1.2m, Height from Floor = 2.5m.

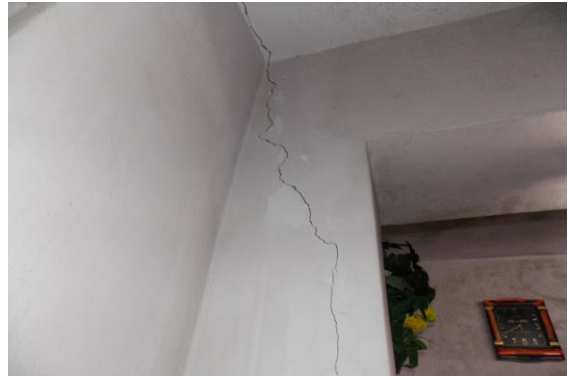
Photo 9

Inclined Crack on Roof & Wall No.4 of Room No. 4, First Floor, Approx. Width = 0.6mm, Approx. Length = 1.3m.
Distance from W1 = 0.25m, Height from Floor = 2m.

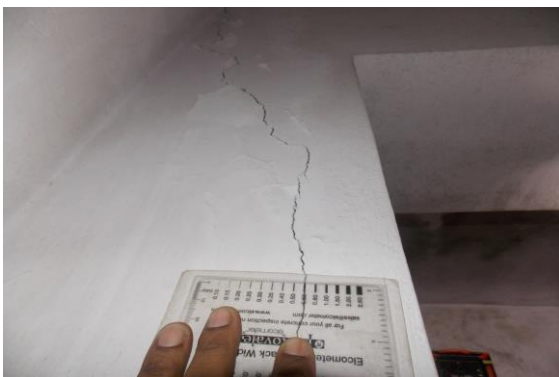
Photo 9A

Inclined Crack on Roof & Wall No.4 of Room No. 4, First Floor, Approx. Width = 0.6mm, Approx. Length = 1.3m.
Distance from W1 = 0.25m, Height from Floor = 2m.

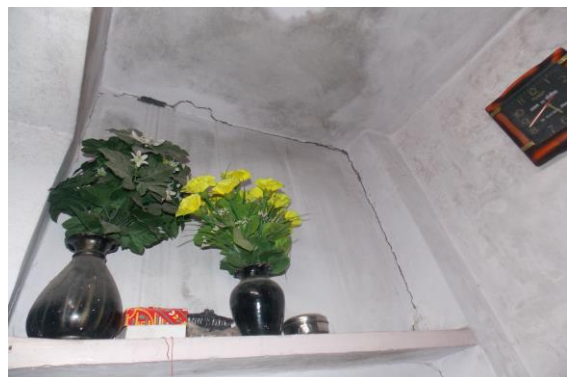
Photo 10

Vertical Crack on Room No. 4, First Floor, Approx. Width = 2mm, Approx. Length = 2.5m.
Distance from W1 = 0m, Height from Floor = 0m.

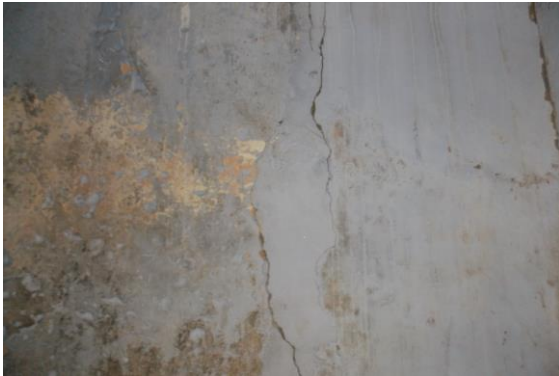
Photo 11

Inclined Crack on Roof of House No. 478, Stair FF to SF, Approx. Width = 1.5mm, Approx. Length = 3m.
Distance from W2 = 0.1m, Height from Floor = 0m.

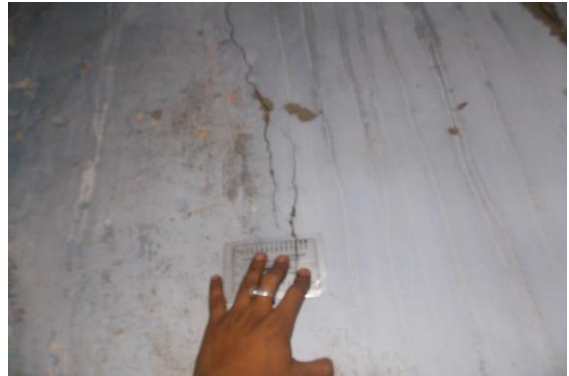
Photo 11A

Inclined Crack on Roof of , House No. 478, Stair FF to SF, Approx. Width = 1.5mm, Approx. Length = 3m.
Distance from W2 = 0.1m, Height from Floor = 0m.

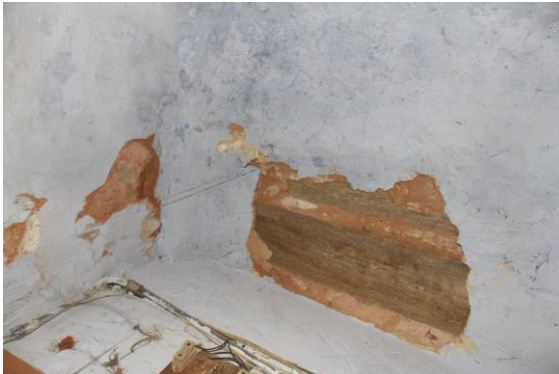
Photo 12

Damaged Portion on Roof & Wall No. 3 of Passage 1 of House No. 478, Ground Floor

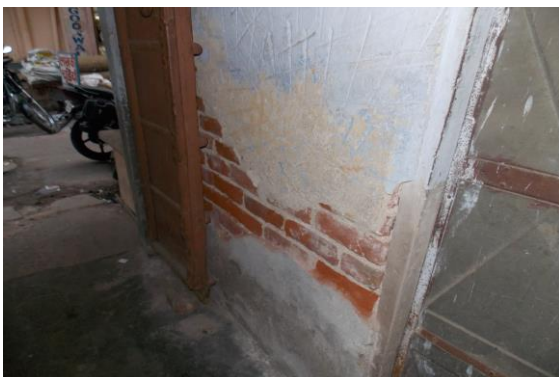
Photo 14

Peeling of Plaster on Passage 1 of House No. 478, Ground Floor

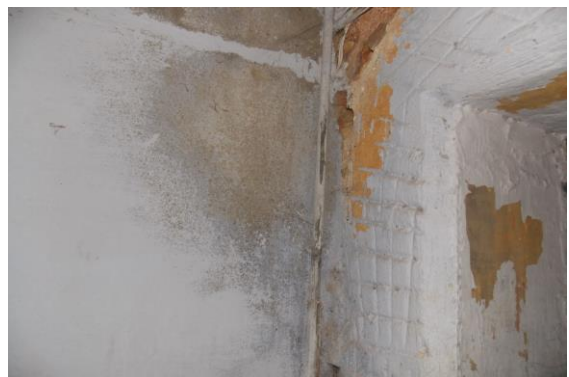
Photo 15

Peeling of Plaster on Open Area 1 of House No. 478, Ground Floor

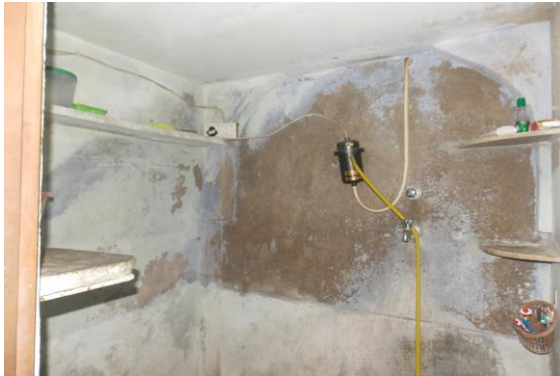
Photo 16
Dampness/Seepage on Bathroom of Ground Floor

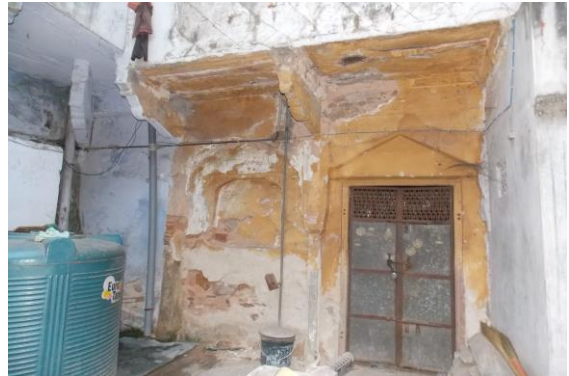
Photo 17
Damaged Portion on Open Area of House No. 478, Ground Floor

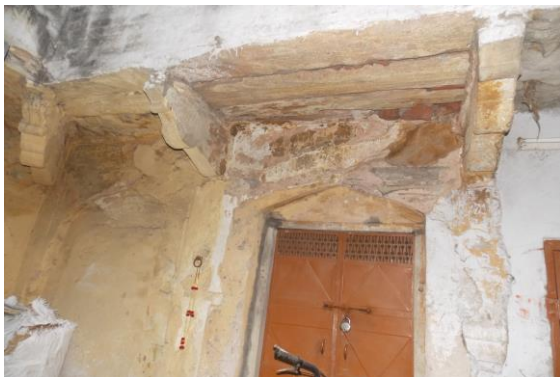
Photo 18
Dampness/Seepage on Open Area of House No. 478, Ground Floor

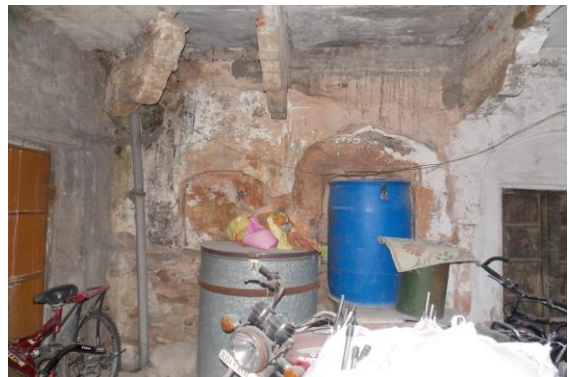
Photo 19
Damaged Portion on Open Area of House No. 478, Ground Floor

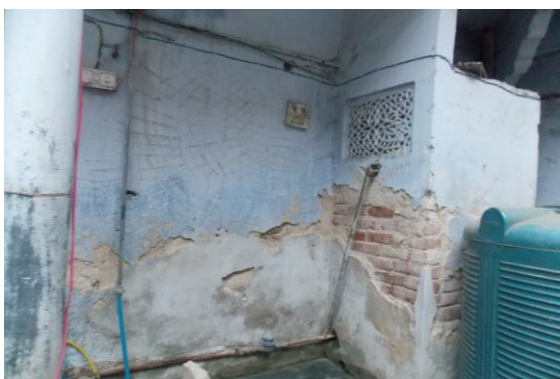
Photo 20
Damaged Portion on Open Area of House No. 478, Ground Floor

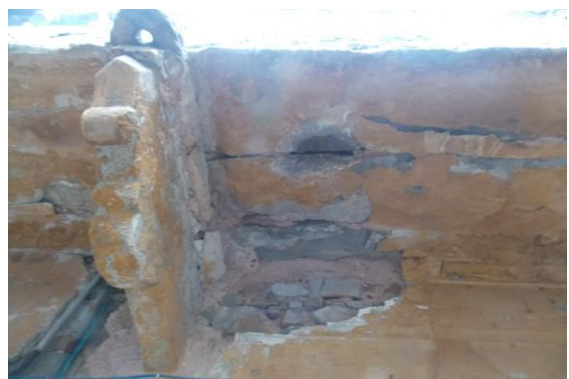
Photo 21
Damaged Portion on Sunshade of Open Area of House No. 478, Ground Floor

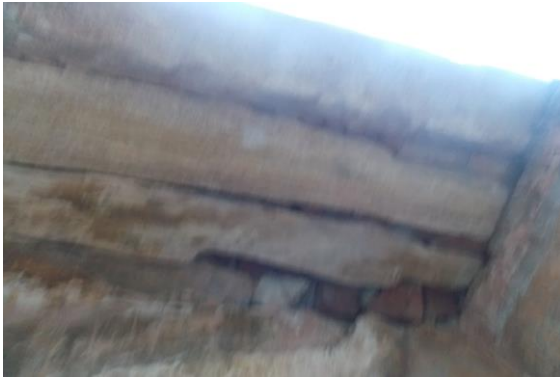
Photo 22

Damaged Portion on Sunshade of Open Area of House No. 478, Ground Floor

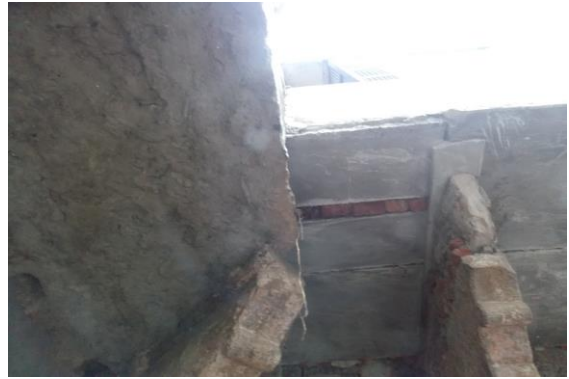
Photo 23

Damaged Portion on Sunshade of Open Area of House No. 478, Ground Floor

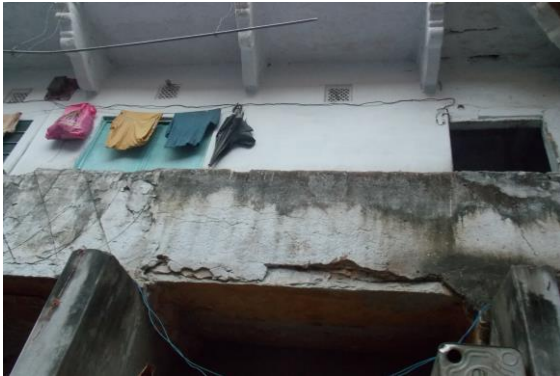
Photo 24

Damaged Portion on Sunshade of Passage 1 of House No. 478, Ground Floor

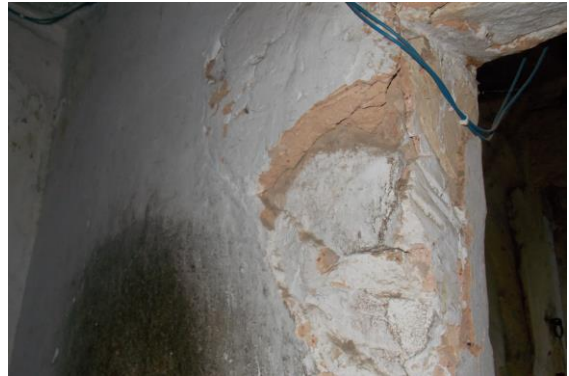
Photo 25

Peeling of Plaster on Stair Case GF to FF of Ground Floor

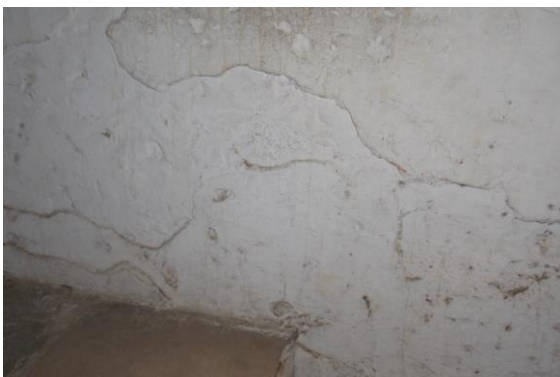
Photo 26

Peeling of Plaster on Stair Case GF to FF of Ground Floor

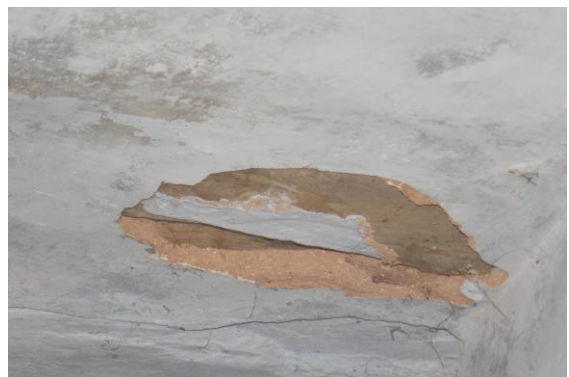
Photo 27

Peeling of Plaster on Roof of House No. 478, Stair FF to SF

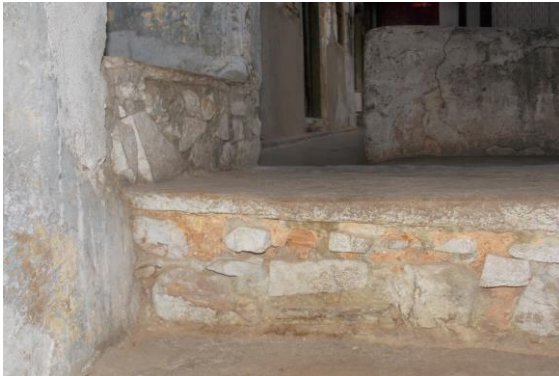
Photo 28

Peeling of Plaster on Step of House No. 478, Stair FF to SF

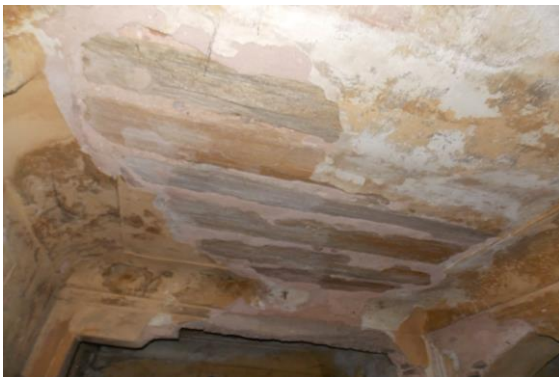
Photo 30

Damaged Portion on Roof of Hall No. 1 of First Floor

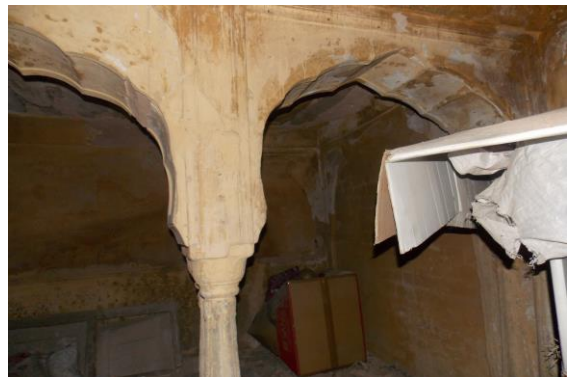
Photo 31

Peeling of Plaster on Roof of Hall No. 1 of First Floor

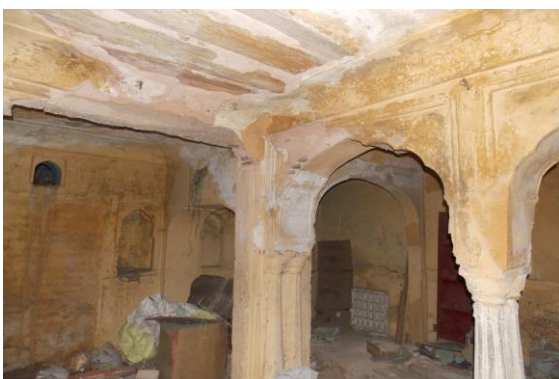
Photo 32

Peeling of Plaster on Roof of Hall No. 1 of First Floor

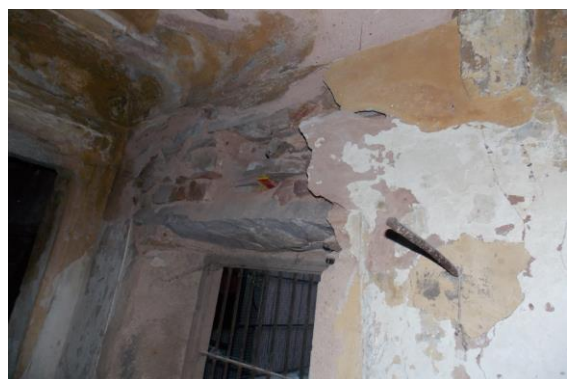
Photo 33

Damaged Portion on Roof of Hall No. 1 of First Floor

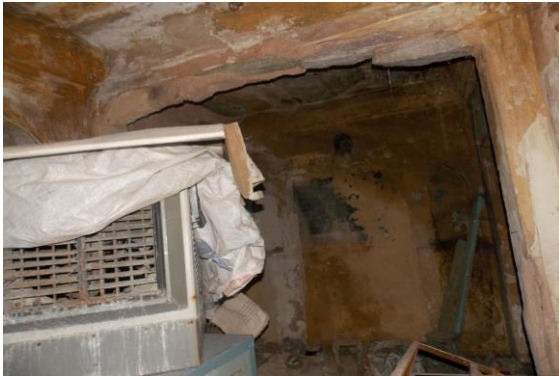
Photo 34
Peeling of Plaster on Roof of Hall No. 1 of First Floor

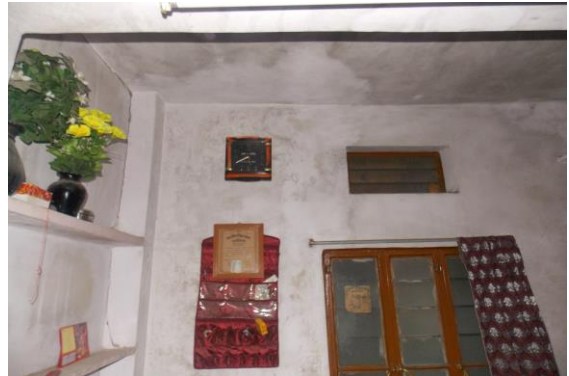
Photo 35
Dampness/Seepage on Roof & Wall No. 4 of Room No. 4 of First Floor

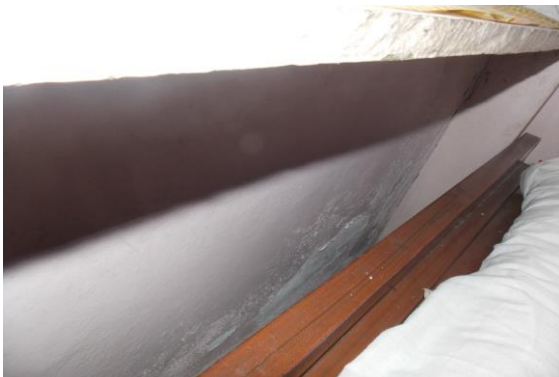
Photo 36
Dampness/Seepage on Room No. 4 of First Floor

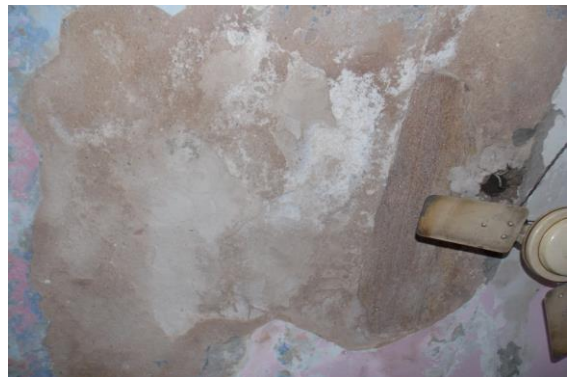
Photo 37
Peeling of Plaster on Roof of Room No. 6 of First Floor

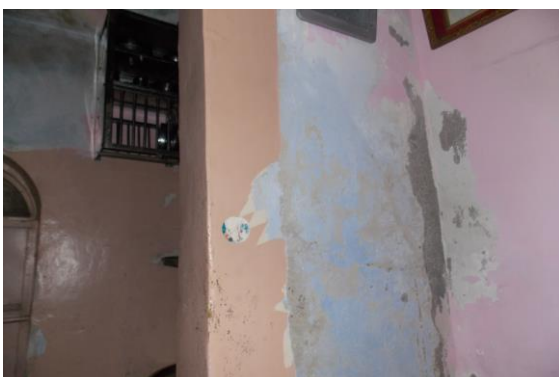
Photo 38
Peeling of Plaster on Roof of Room No. 6 of First Floor

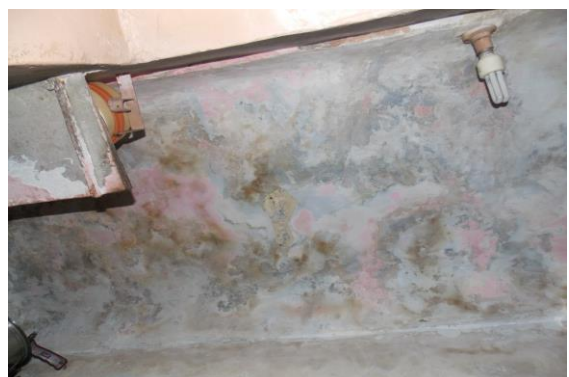
Photo 39
Dampness/Seepage on Roof of Balcony of House No. 478, First Floor

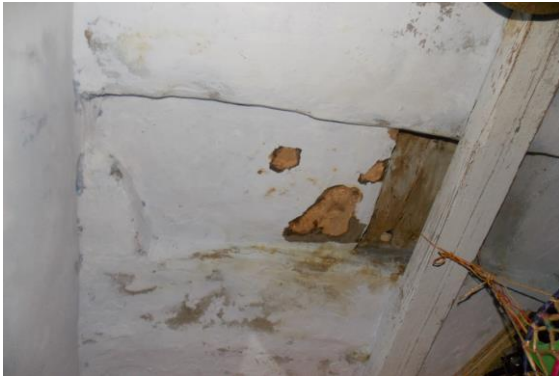
Photo 40
Peeling of Plaster on Roof of Room No. 5 of First Floor

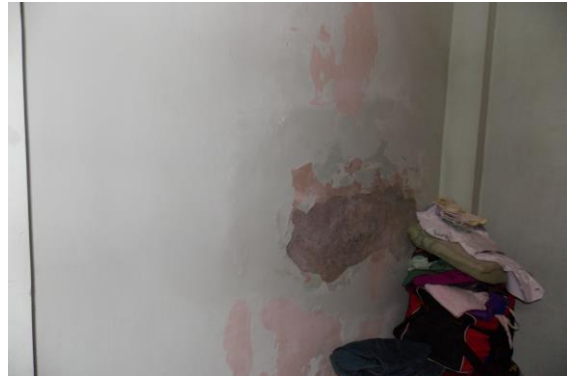
Photo 41
Peeling of Plaster on All Walls & Wall No.4 of Room No. 7 of First Floor

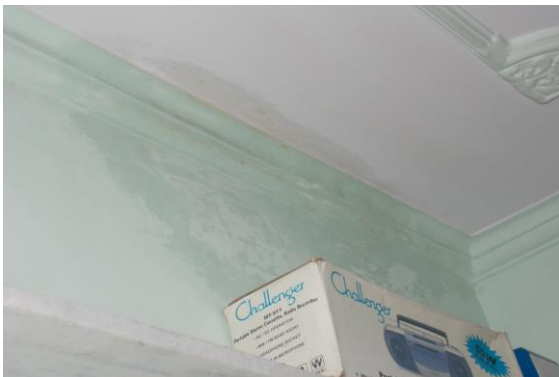
Photo 42
Dampness/Seepage on All Walls & Wall No. 4 of Room No. 7 of First Floor

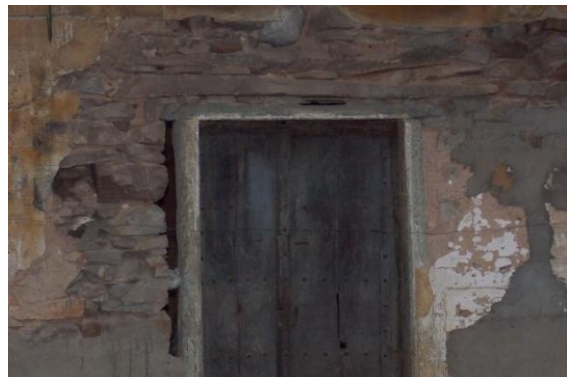
Photo 43
Damaged Portion on Open Area of House No. 478, First Floor

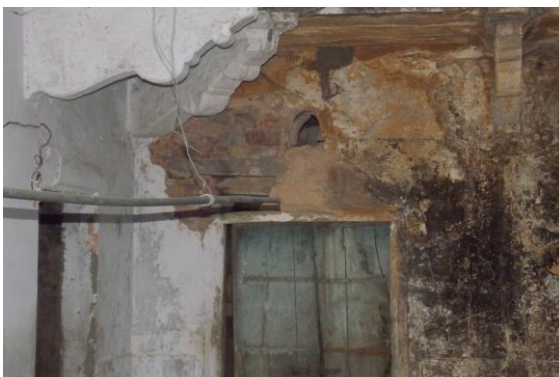
Photo 44
Damaged Portion on Open Area of House No. 478, First Floor

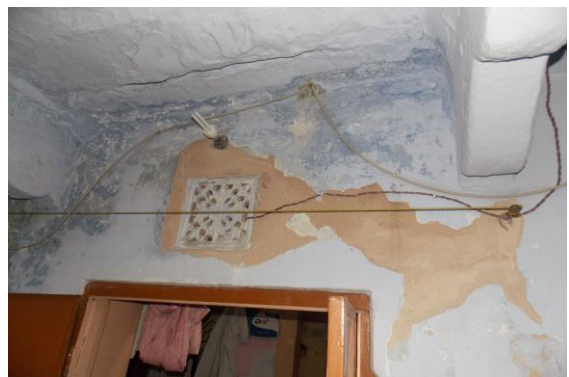
Photo 45
Damaged Portion on Open Area of House No. 478, First Floor

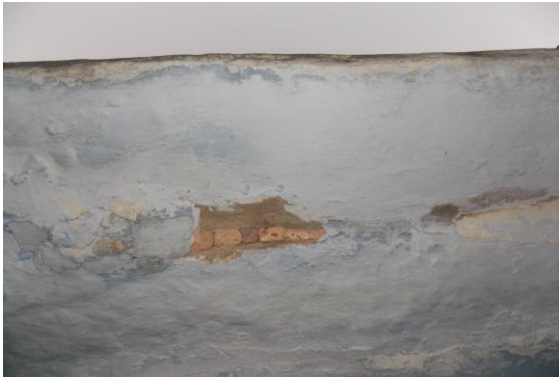
Photo 46

Damaged Portion on Sunshade of Open Area of House No. 478, First Floor

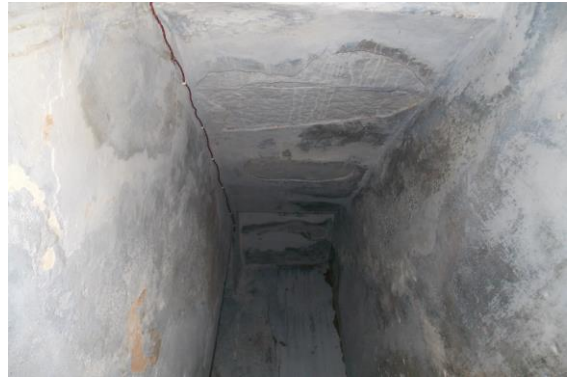
Photo 47

Dampness/Seepage on All Walls of House No. 478, Stair FF to SF

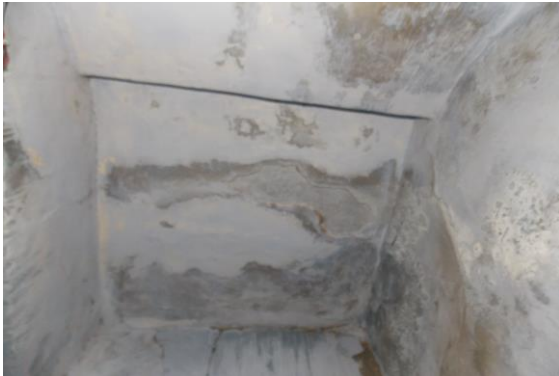
Photo 48

Dampness/Seepage on Roof of House No. 478, Stair FF to SF

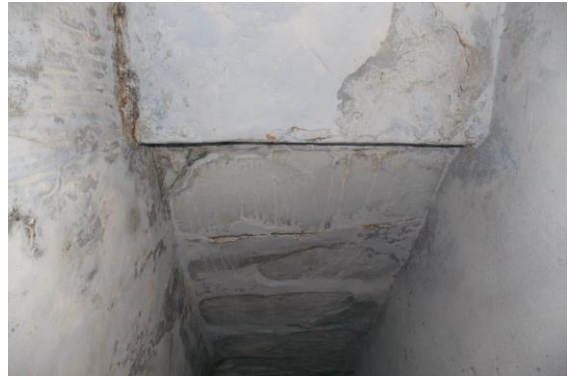
Photo 49

Peeling of Plaster on Roof of House No. 478, Stair FF to SF

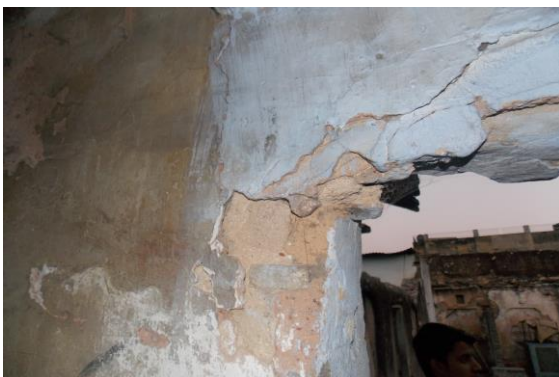
Photo 50

Peeling of Plaster on Roof of House No. 478, Stair FF to SF

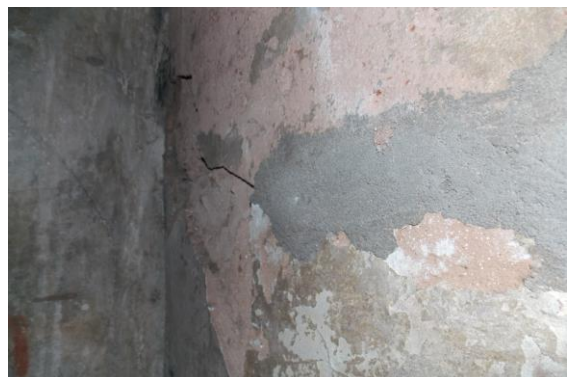
Photo 51

Peeling of Plaster on Roof of House No. 478, Stair FF to SF

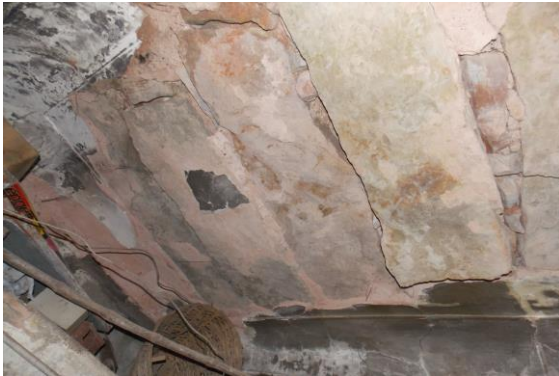
Photo 52

Damaged Portion on Roof of Varanda 1 of House No. 478, Second Floor

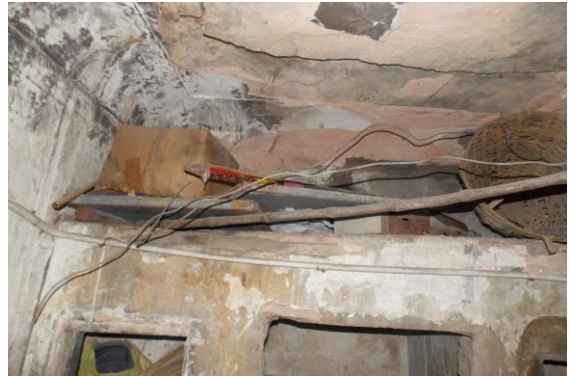
Photo 53

Damaged Portion on Roof of Varanda 1 of House No. 478, Second Floor

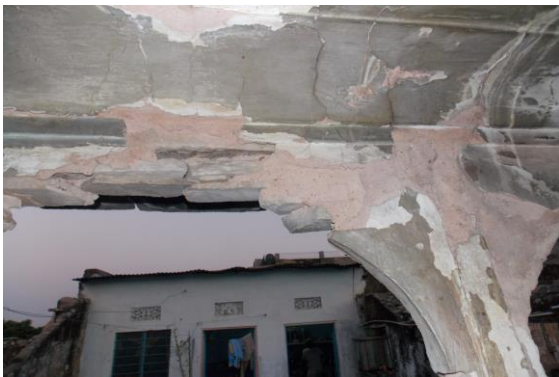
Photo 54

Damaged Portion on Roof of Varanda 1 of House No. 478, Second Floor

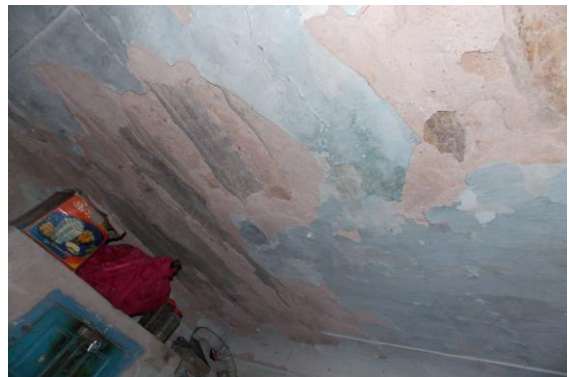
Photo 55

Damaged Portion on Roof of Varanda 1 of House No. 478, Second Floor

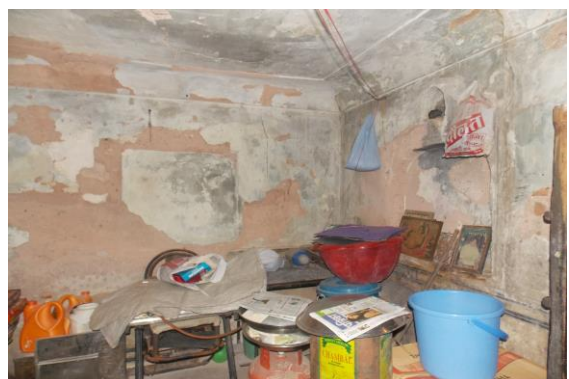
Photo 57

Damaged Portion on Roof & All wall of Room No. 1 of Second Floor

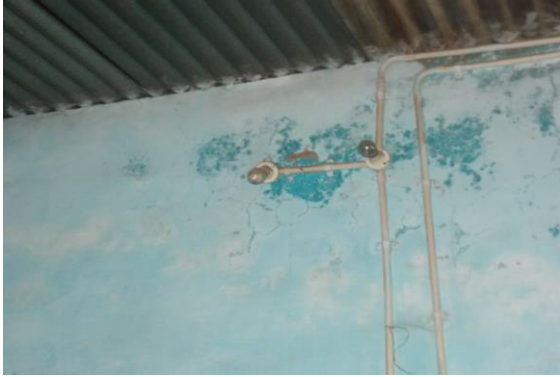
Photo 58

Dampness/Seepage on Roof & All wall of Room No. 1 of Second Floor

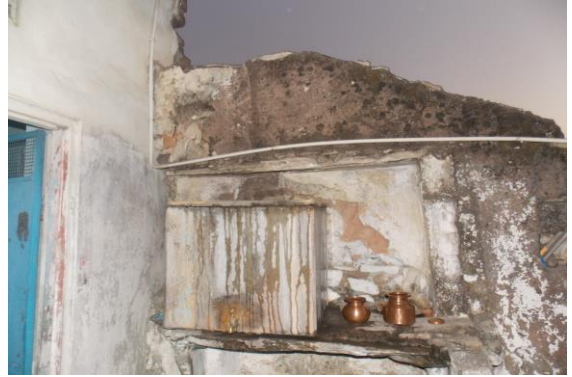
Photo 59

Damaged Portion on Roof of Room No. 2 of Second Floor

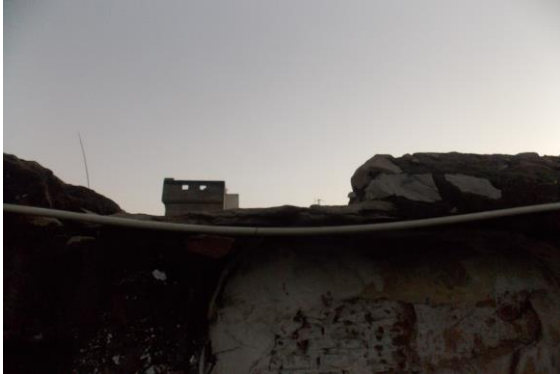
Photo 60

Damaged Portion on Roof of Kitchen of House No. 478, Second Floor

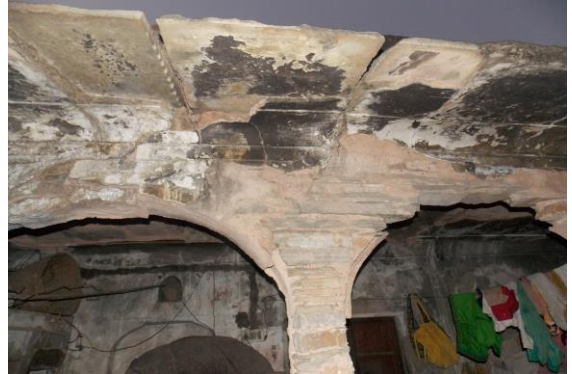
Photo 61

Damaged Portion on Roof of Open Area 1 of House No. 478, Second Floor

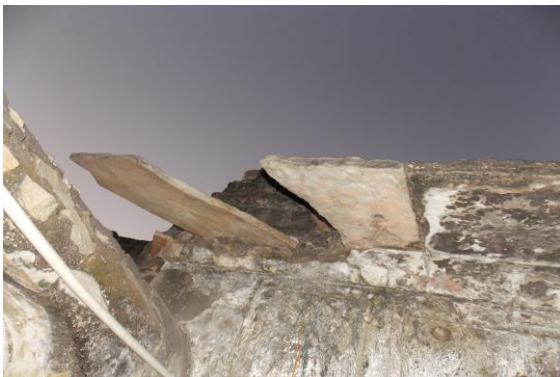
Photo 62

Damaged Portion on Roof of Open Area 1 of House No. 478, Second Floor

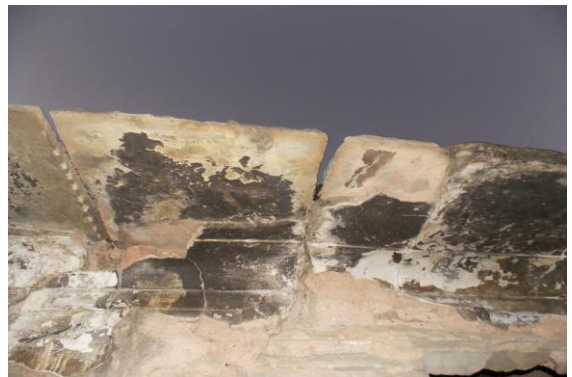
Photo 63

Damaged Portion on Sunshade & Wall No.1 of Open Area 1 of House No. 478, Second Floor

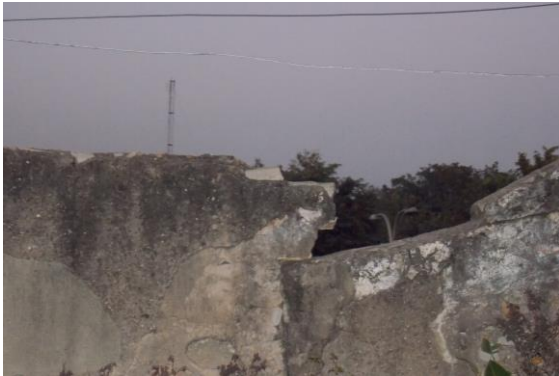
Photo 64

Damaged Portion on Sunshade & Wall No.1 of Open Area 1 of House No. 478, Second Floor

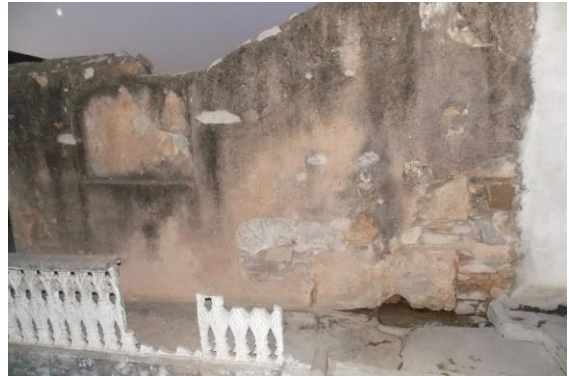
Photo 65

Damaged Portion on Sunshade & Wall No.1 of Open Area 1 of House No. 478, Second Floor

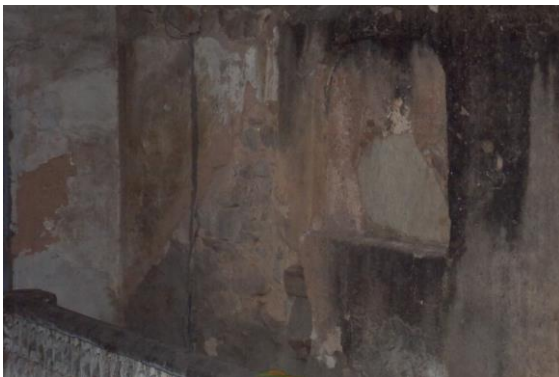
Photo 66

Damaged Portion on Sunshade & Wall No. 1 of Open Area 1 of House No. 478, Second Floor

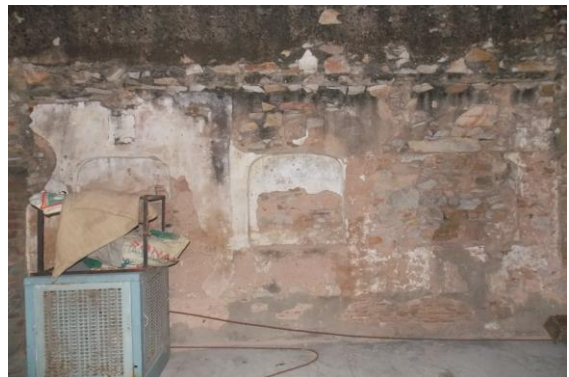
Photo 67

Damaged Portion on Sunshade & Wall No. 1 of Open Area 1 of House No. 478, Second Floor

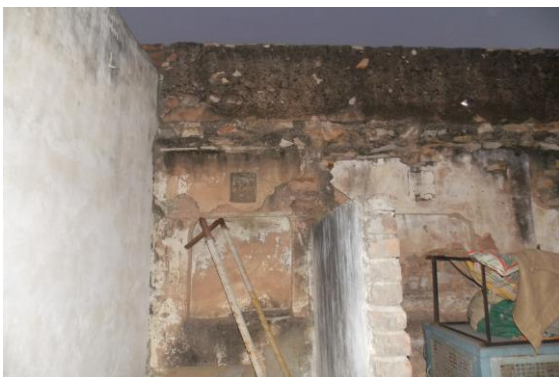
Photo 68

Damaged Portion on Sunshade & Wall No.1 of Open Area 1 of House No. 478, Second Floor

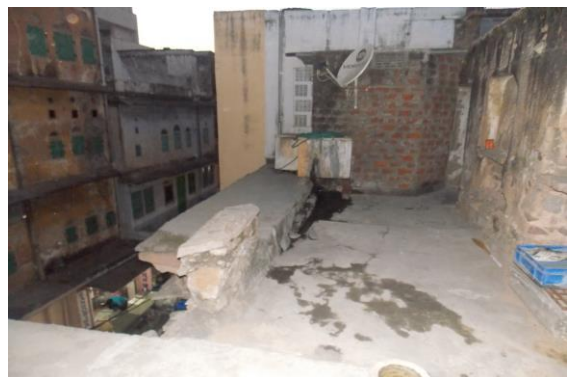
Photo 69

Damaged Portion on Sunshade & Wall No.1 of Open Area 1 of House No. 478, Second Floor

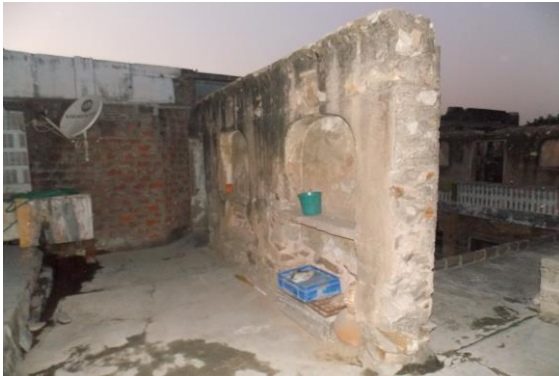
Photo 70

Damaged Portion on Sunshade & Wall No.1 of Open Area 1 of House No. 478, Second Floor

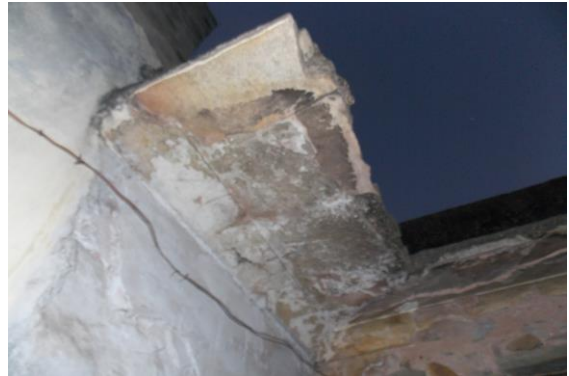
Photo 71

Damaged Portion on Room No. 4 of Second Floor

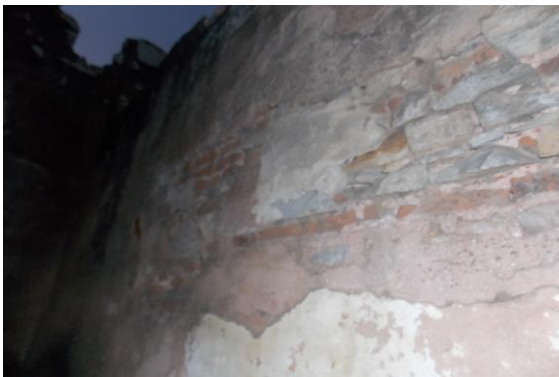
Photo 72

Damaged Portion of Room No. 5 of Second Floor

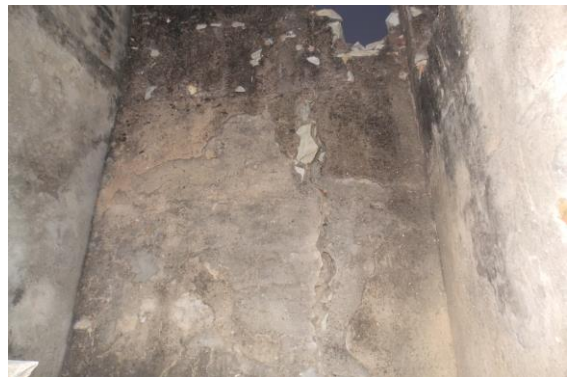
Photo 73

Damaged Portion on Sunshade of Open Area 2 of House No. 478, Second Floor

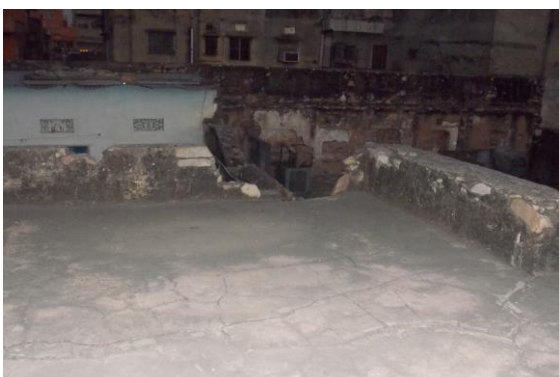
Photo 74

Damaged Portion on Sunshade of House No. 478, Stair SF to Terrace

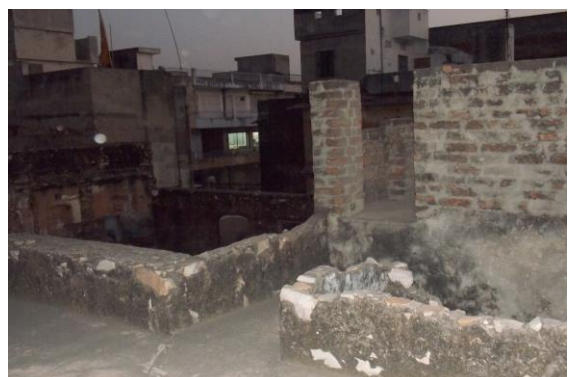
Photo 75

Damaged Portion on Sunshade of House No. 478, Stair SF to Terrace

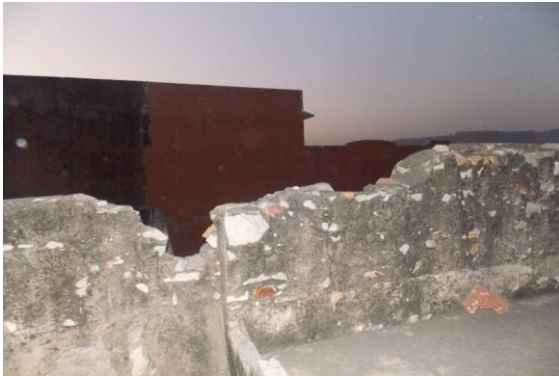
Photo 76

Damaged Portion on Sunshade of Passage of House No. 478, Second Floor

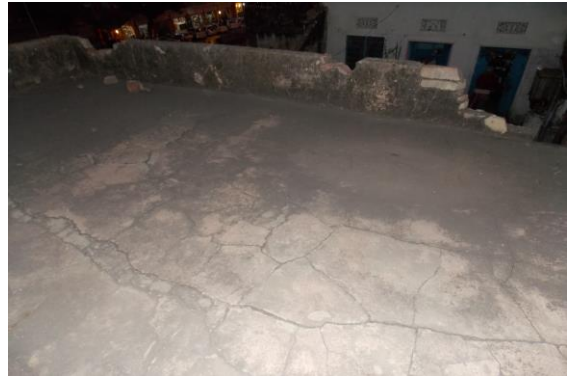
Photo 77

Damaged Portion on Sunshade of Passage of House No. 478, Second Floor

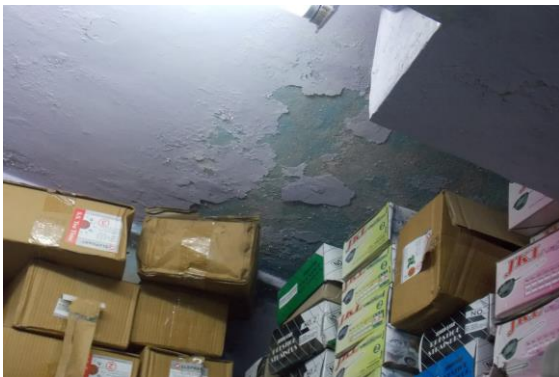
Photo 78

Dampness/Seepage on Shop 1 of Ground Floor

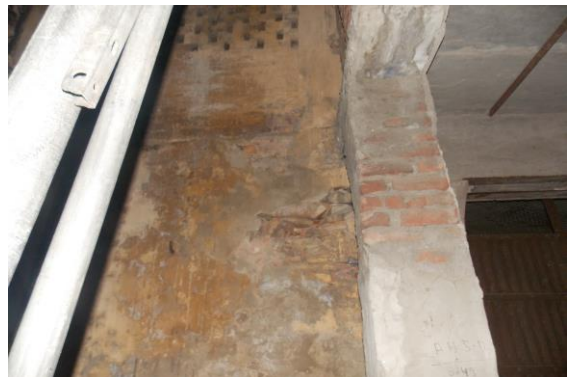
Photo 79

Damaged Portion on All Wall of Shop 1 of Ground Floor

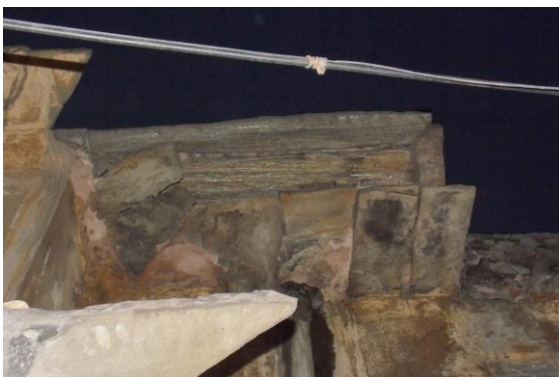
Photo 80

Damaged Portion on Roof of Shop 1 of Ground Floor

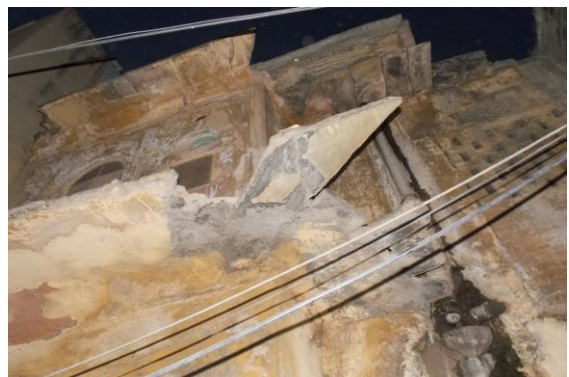
Photo 81

Damaged Portion on Front Side Wall of External Façade

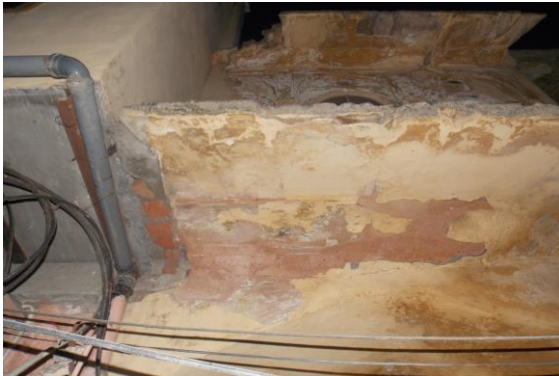
Photo 82
Peeling of Plaster on Front Side Wall of External Façade

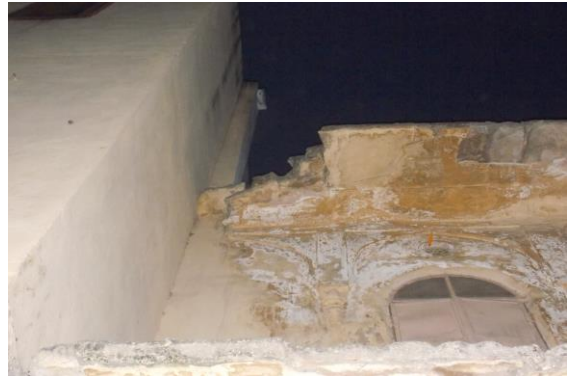
Photo 83
Peeling of Plaster on Front Side Wall of External Façade

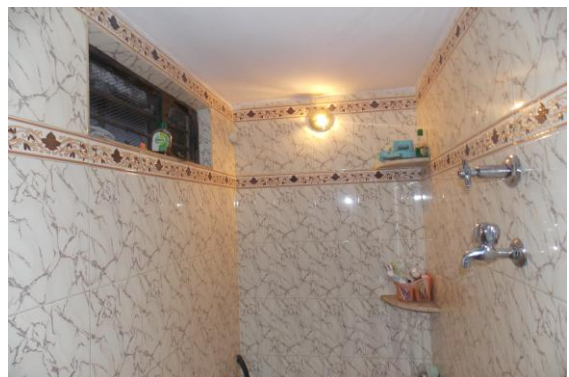
Photo 99
All Walls of Bathroom No. 1 of First Floor Covered With Tiles.

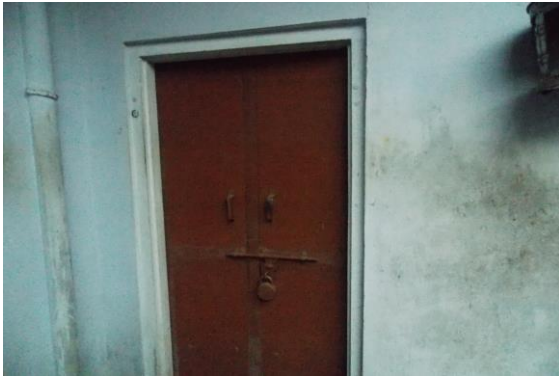
Photo 100
Room No. 8 of First Floor Covered

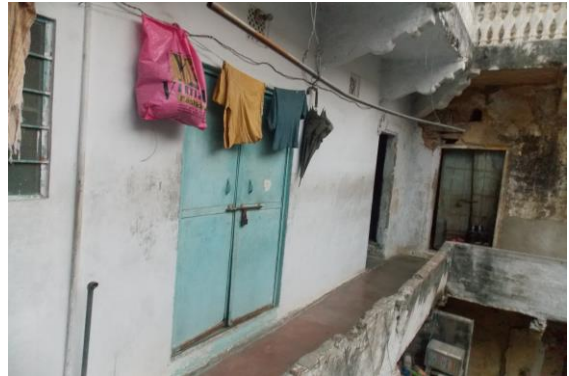
Photo 101
Room No. 9 of First Floor Covered
