Pre Building Condition Survey Report

Name and Address of Structure :	Choti Chopar to Badi Chopar (Down Line)
---------------------------------	---

Name of the Project	Contract JMRC-UG1B “Design and Construction of Tunnel between Chandpole and Badi Chouper and reverse line by Shield TBM, Underground Metro Stations at Choti Chouper and Badi Chouper by Cut and Cover Methods on East West Corridor of Jaipur Metro Rail Corporation Limited .”	
Owner :

Pre Building Condition Survey Report Choti Chopar to Badi Chopar (Down Line)

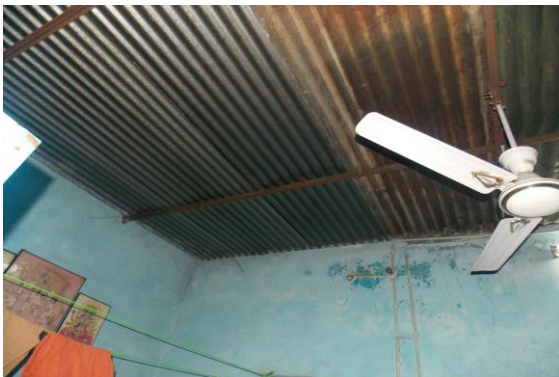
Photo 102
Roof & All wall of Room No. 1 of Second Floor Covered

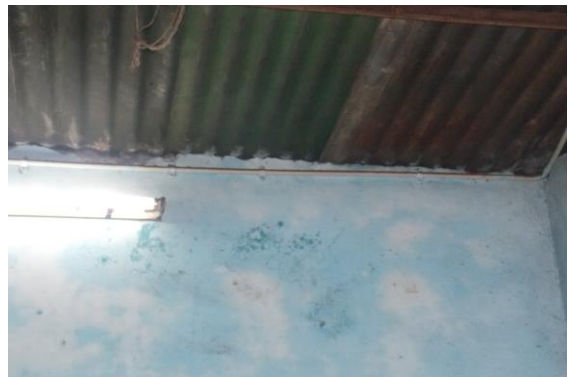
Photo 103
Roof of Room No. 2 of Second Floor Covered

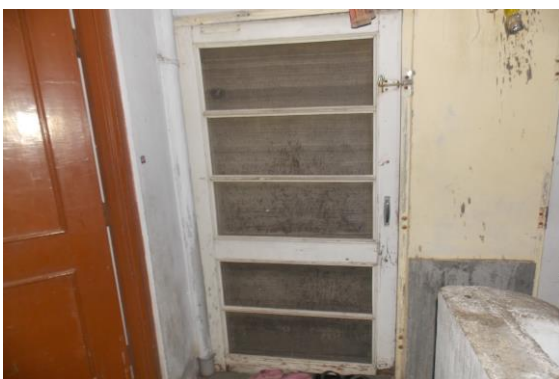
Photo 104
Sunshade of Open Area 1 of House No. 478, Second Floor Covered

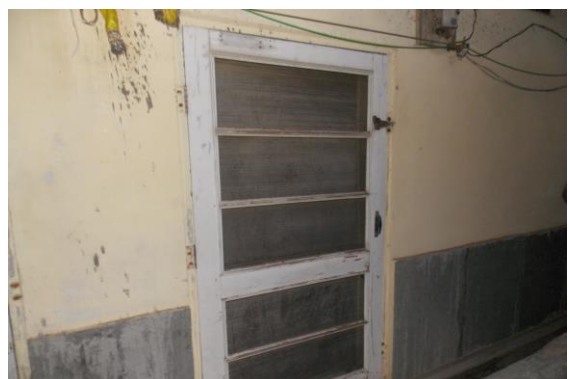
Photo 105
Room No. 3 of Second Floor Covered

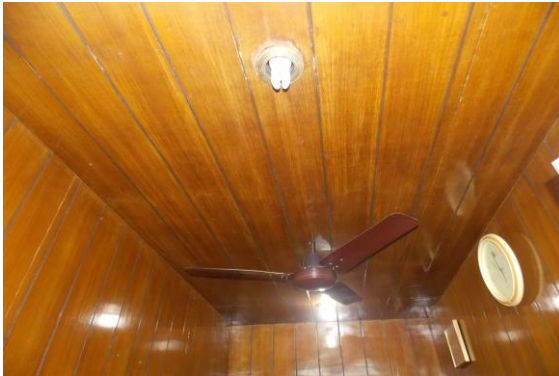
Photo 108

Shop 2 of Ground Floor Covered With Wood

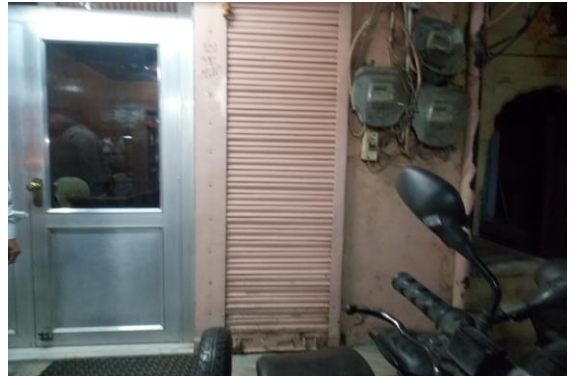
Photo 109

All Wall of Shop 2 of Ground Floor

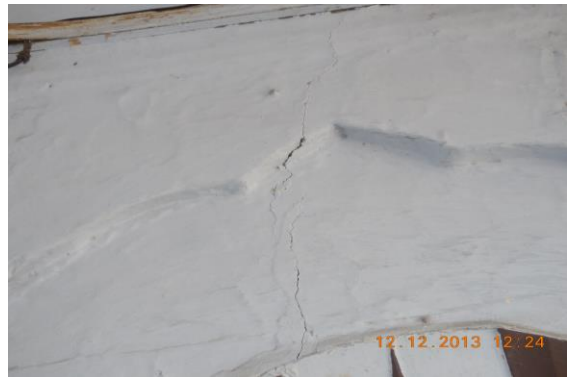
Photo 4
Inclined Crack on Open Sky, House No. 483, First Floor, Approx. Width = 0.4mm, Approx. Length = 0.9m. Distance from Wall No. 1 = 1m, Height from Floor = 2.2m.

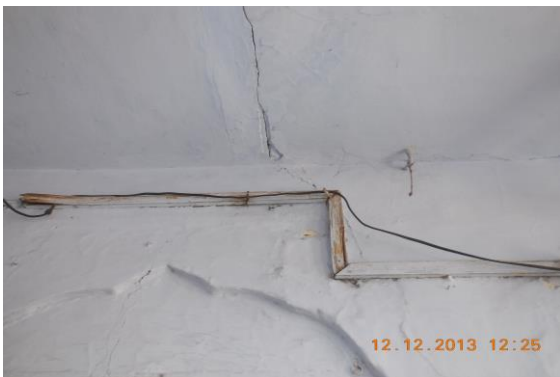
Photo 5
Inclined Crack on Wall No. 4 & Sunshade of Open Sky, House No. 483, First Floor, Approx. Width = 5mm, Approx. Length = 2.5m. Distance from Wall No. 1 = 1.6m, Height from Floor = 2.5m.

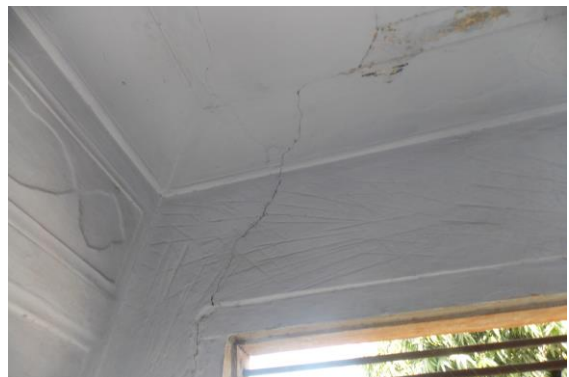
Photo 6
Inclined Crack on Wall No. 4 & Roof of Vranda, House No. 483, First Floor, Approx. Width = 2mm, Approx. Length = 2m. Distance from Wall No. 1 = 2.7m, Height from Floor = 1.9m.

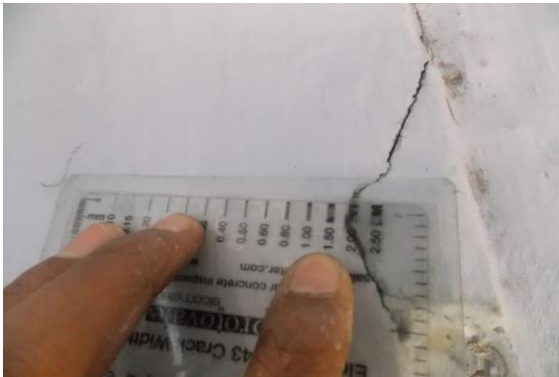
Photo 7

Inclined Crack on Wall No.4& Roof of Vranda, House No. 483, First Floor, Approx. Width = 2mm, Approx. Length = 2m.
Distance from Wall No.1 = 2.7m, Height from Floor = 1.9m.

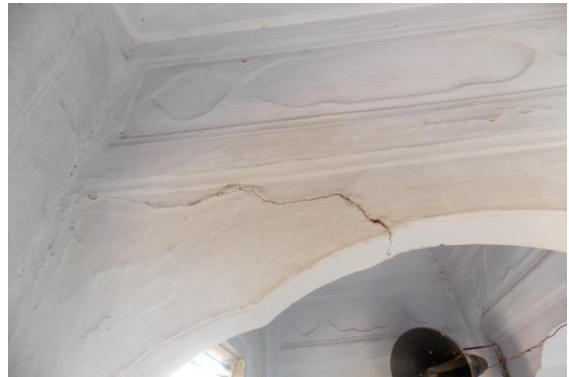
Photo 8

Inclined Crack on Wall No. 2&Roof of Vranda, House No. 483, First Floor, Approx. Width = 8mm, Approx. Length = 0.8m.
Distance from Wall No.4 = 0.3m, Height from Floor = 2.1m.

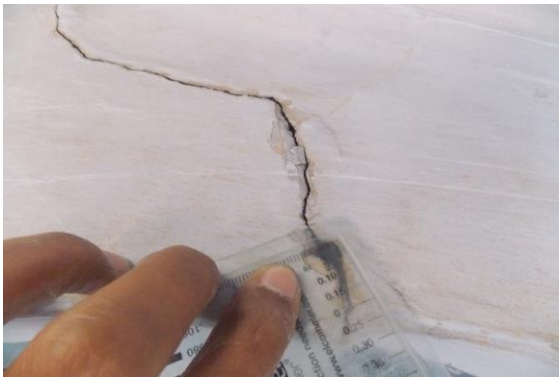
Photo 8A

Inclined Crack on Wall No. 2&Roof of Vranda, House No. 483, First Floor, Approx. Width = 8mm, Approx. Length = 0.8m.
Distance from Wall No.4 = 0.3m, Height from Floor = 2.1m.

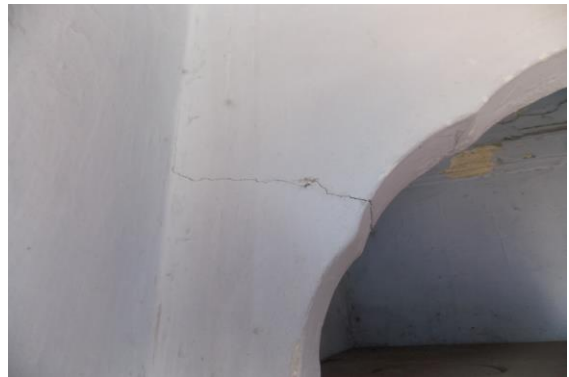
Photo 9

Inclined Crack on Wall No.2 & Roof of Vranda, House No. 483, First Floor, Approx. Width = 0.4mm, Approx. Length = 0.3m.
Distance from Wall No.4 = 0.2m, Height from Floor = 2m.

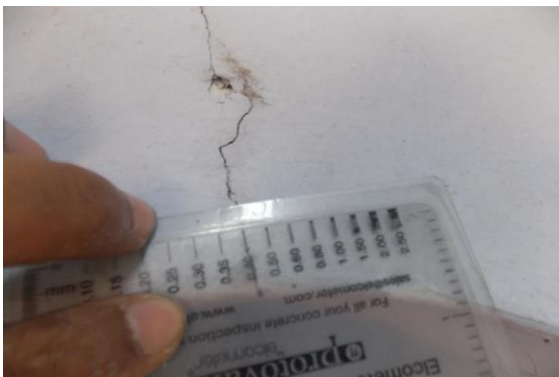
Photo 9A

Inclined Crack on Wall No.2& Roof of Vranda, House No. 483, First Floor, Approx. Width = 0.4mm, Approx. Length = 0.3m.
Distance from Wall No.4 = 0.2m, Height from Floor = 2m.

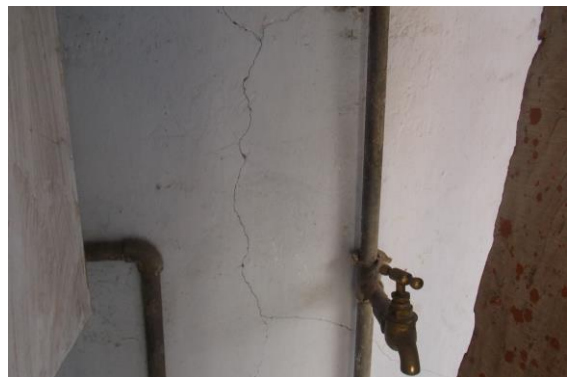
Photo 10

Inclined Crack on Wall No.2& Roof of Vranda, House No. 483, First Floor, Approx. Width = 0.2mm, Approx. Length = 2m.
Height from Floor = 0.5m.

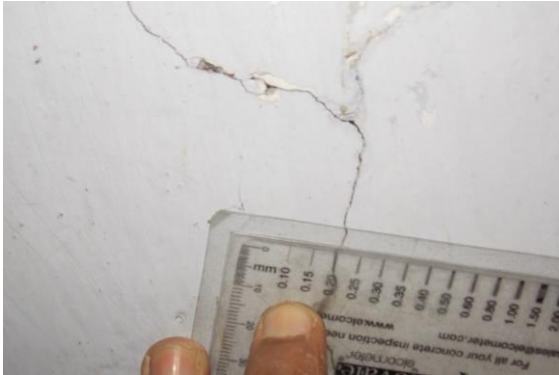
Photo 10A

Inclined Crack on Wall No. 2 & Roof of Vranda, House No. 483, First Floor, Approx. Width = 0.2mm, Approx. Length = 2m.
Height from Floor = 0.5m.

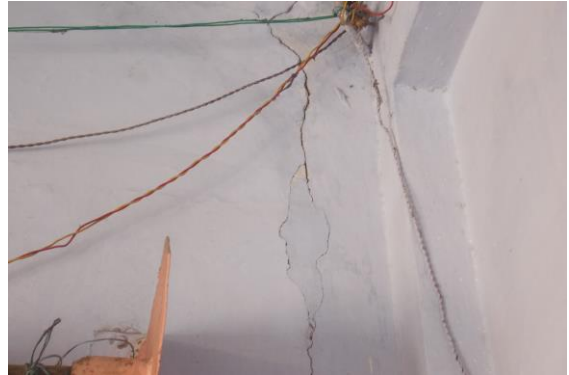
Photo 11

Vertical Crack on Wall No. 2 & Roof of Sky open, House No. 483, First Floor, Approx. Width = 0.5mm, Approx. Length = 3.5m.
Distance from Wall No. 1 = 0.5m, Height from Floor = 0m.

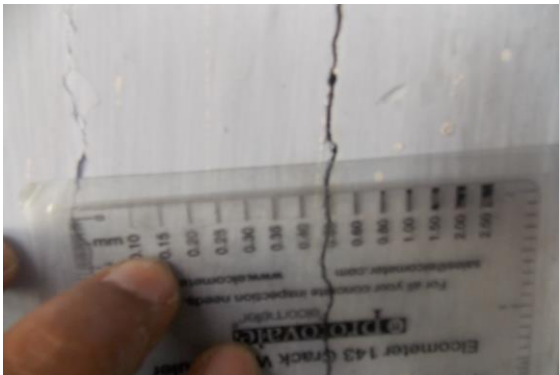
Photo 11A

Vertical Crack on Wall No. 2 & Roof of Sky open, House No. 483, First Floor, Approx. Width = 0.5mm, Approx. Length = 3.5m.
Distance from Wall No. 1 = 0.5m, Height from Floor = 0m.

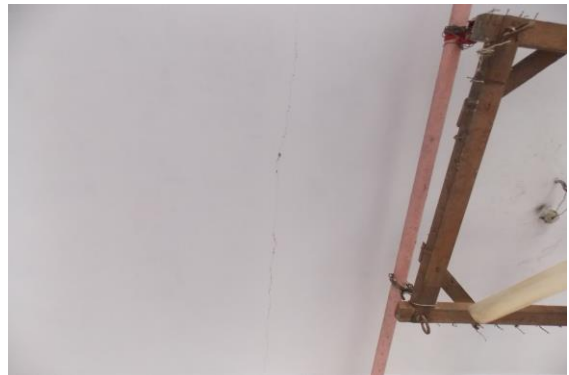
Photo 12

Horizontal Crack on Roof of Vrand-2, House No. 483, First Floor, Approx. Width = 0.35mm, Approx. Length = 2.5m.
Distance from Wall No. 1 = 1.6m, Height from Floor = 2.2m.

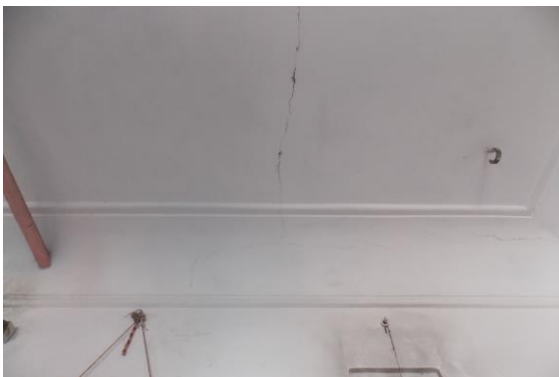
Photo 13

Horizontal Crack on Wall No. 4 & Roof of Vranda-2, House No. 483, First Floor, Approx. Width = 0.4mm, Approx. Length = 2m.
Distance from Wall No. 2 = 1.5m, Height from Floor = 2.2m.

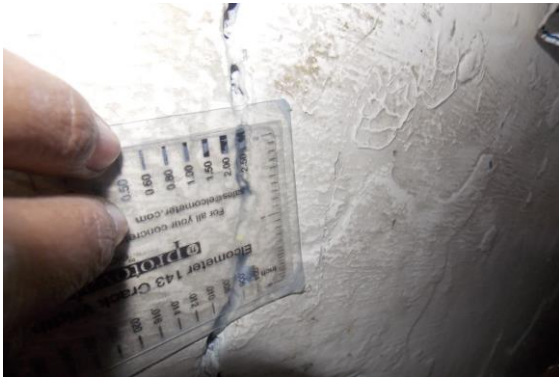
Photo 14A

Horizontal Crack on Roof of Room No. 1, First Floor, Approx. Width = 2.5mm, Approx. Length = 0.5m. Distance from Wall No.3 = 3.5m, Height from Floor = 0.4m.

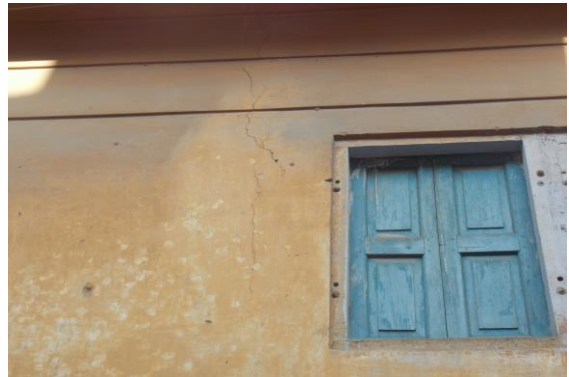
Photo 15

Inclined Crack of Back Side, House No. 483, Ground Floor, Approx. Width = 2mm, Approx. Length = 2m. Distance from Left side of building = 1m, Height from Floor = 2.8m.

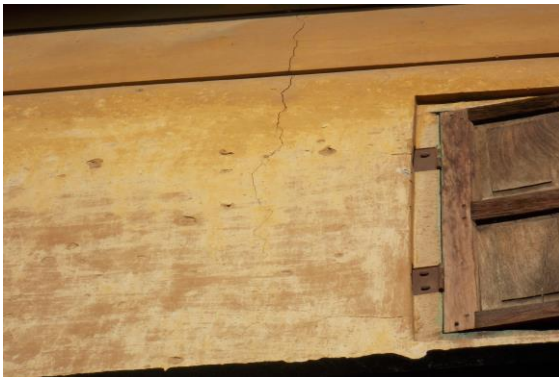
Photo 16

Inclined Crack on Back Side, House No. 483, Ground Floor, Approx. Width = 1.8mm, Approx. Length = 1m. Distance from Left side of building = 1.8m, Height from Floor = 5m.

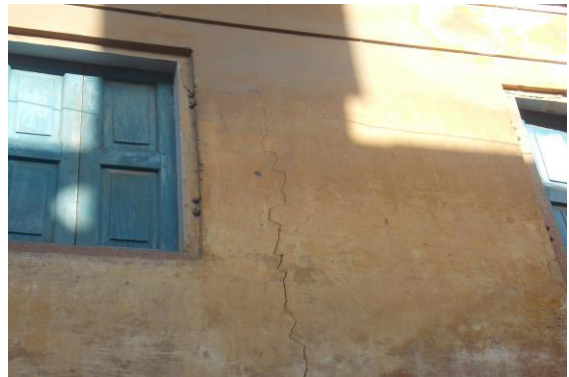
Photo 17

Inclined Crack on Back Side, House No. 483, Ground Floor, Approx. Width = 1mm, Approx. Length = 1.2m. Distance from Left side of building = 1.2m, Height from Floor = 2m.

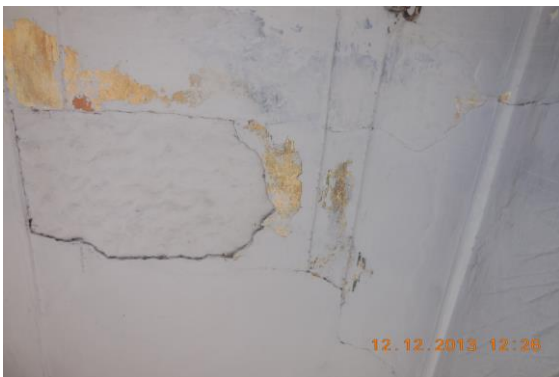
Photo 18

Peeling of Plaster on Roof of Vanda of House No. 483, First Floor

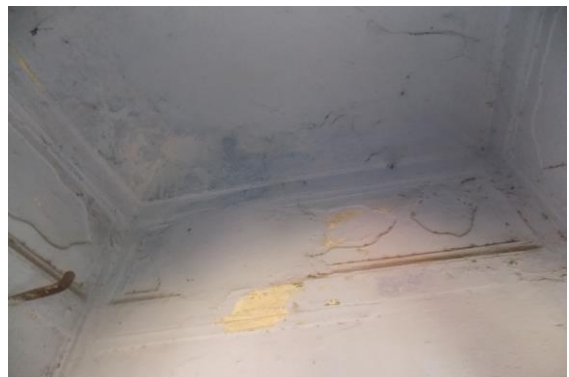
Photo 19

Peeling of Plaster on Wall No. 2 & Roof of Vanda of House No. 483, First Floor

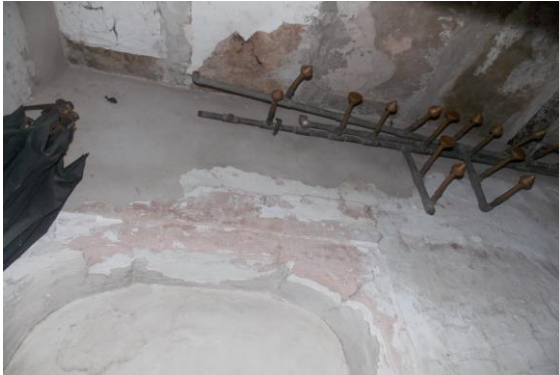
Photo 20
Dampness/Seepage on Wall No. 4 & Roof of Store of House No. 483,
First Floor

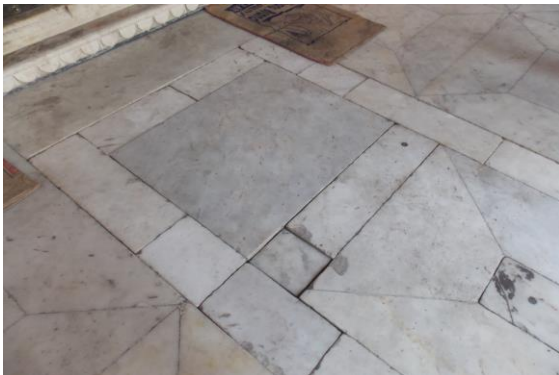
Photo 22
Dampness/Seepage on Floor of Vrand-2 of House No. 483, First Floor

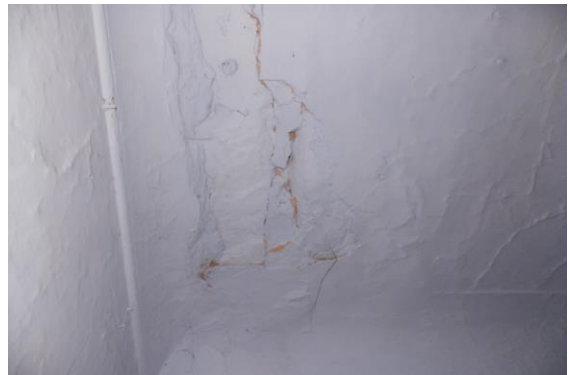
Photo 23
Peeling of Plaster on Roof of Room No. 1 of First Floor

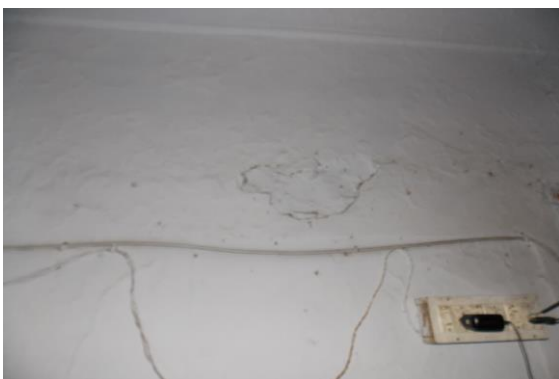
Photo 24
Peeling of Plaster on Roof of Room No. 1 of First Floor

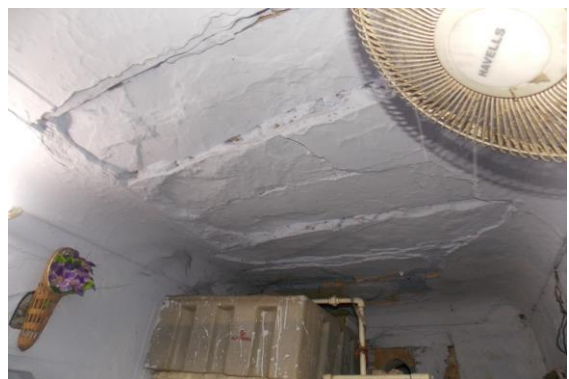
Photo 25
Dampness/Seepage on Roof of Room No. 1 of First Floor

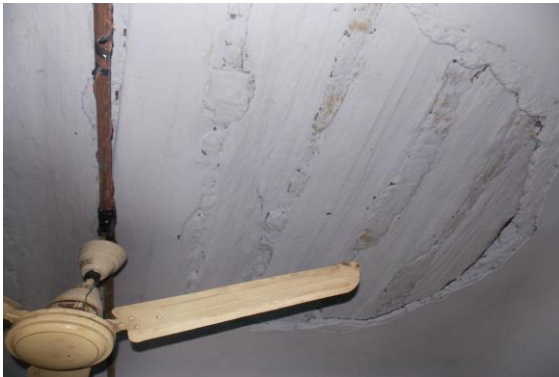
Photo 26

Dampness/Seepage on Roof of Room No. 2 of House No. 483, First Floor

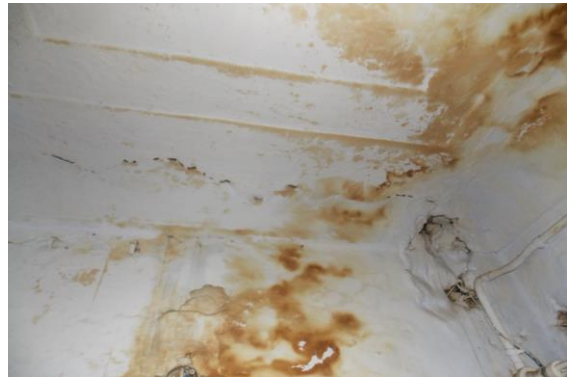
Photo 27

Dampness/Seepage on Wall No.2 & Roof of Kitchen of House No. 483, First Floor

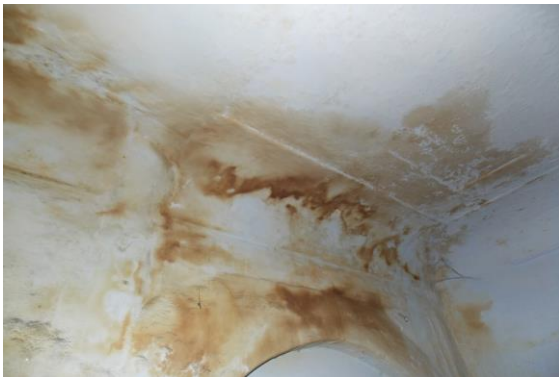
Photo 28

Dampness/Seepage on Wall No.3 & Roof of Kitchen of House No. 483, First Floor

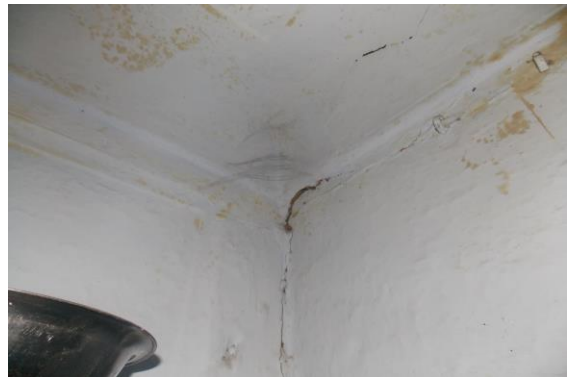
Photo 29

Peeling of Plaster on Wall No.3 & Roof of Kitchen of House No. 483, First Floor

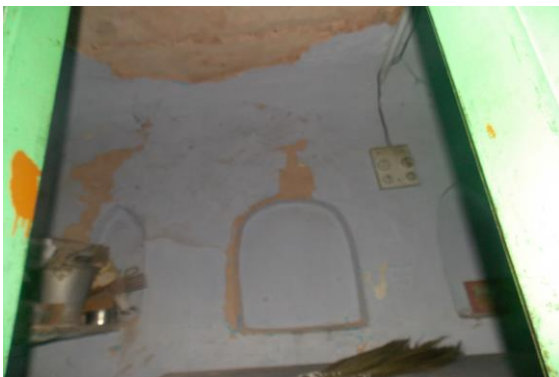
Photo 30

Peeling of Plaster on Wall No.4 & Roof of Room No. 3 of First Floor

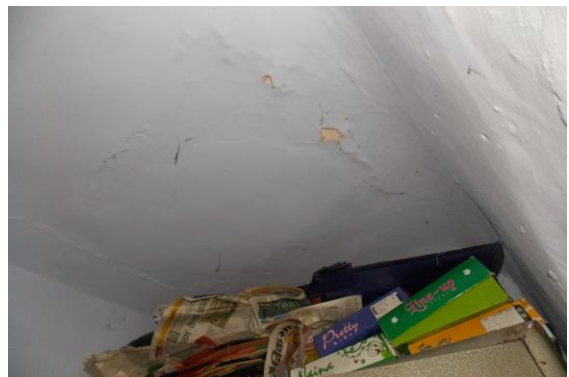
Photo 31

Peeling of Plaster on Roof of Room No. 4 of First Floor

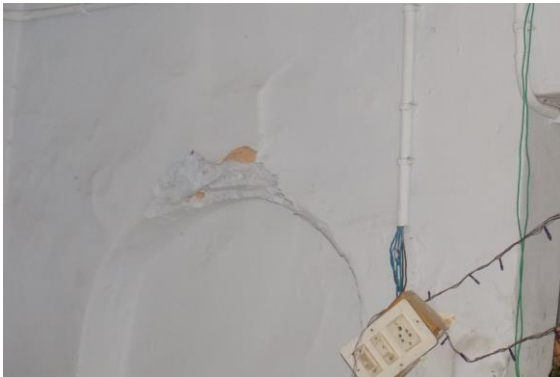
Photo 32

Peeling of Plaster on Roof of Lobby1 of House No. 483, First Floor

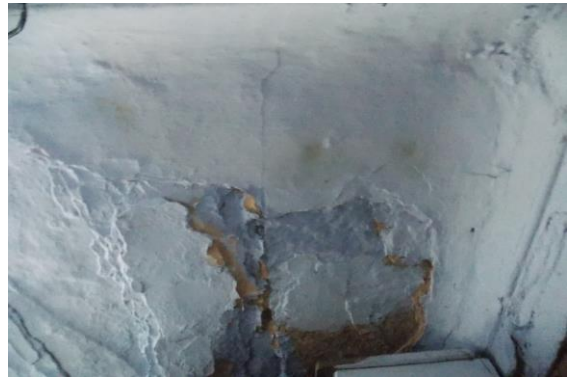
Photo 33

Dampness/Seepage on Roof of Bathroom of First Floor

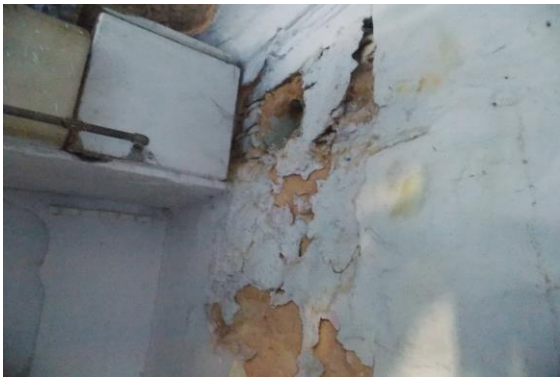
Photo 34

Dampness/Seepage on Roof of Bathroom of First Floor

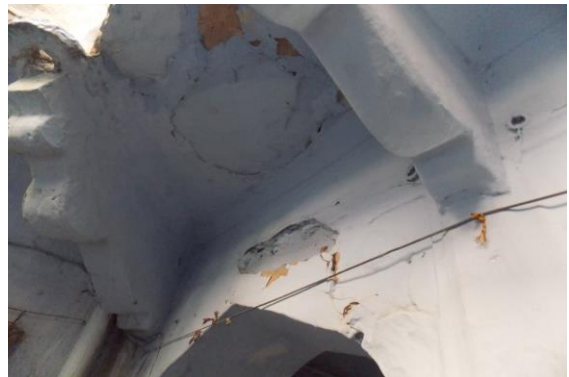
Photo 35

Peeling of Plaster on Wall No.1 & Roof of Sky Open Vrand-3 of House No. 483, First Floor

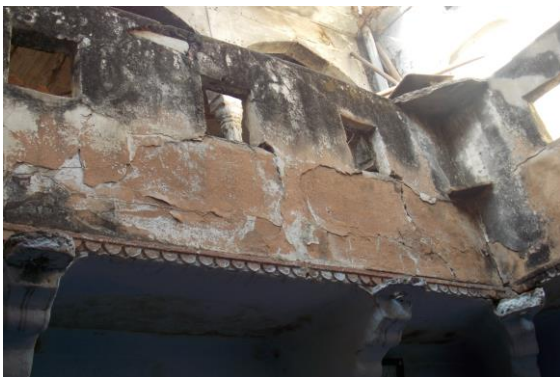
Photo 36

Dampness/Seepage on parapet wall of Sky Open Vrand-3 of House No. 483, First Floor

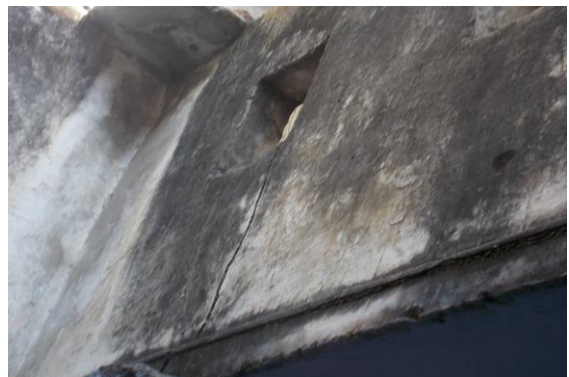
Photo 37

Dampness/Seepage on parapet wall of Sky Open Vrand-3 of House No. 483, First Floor

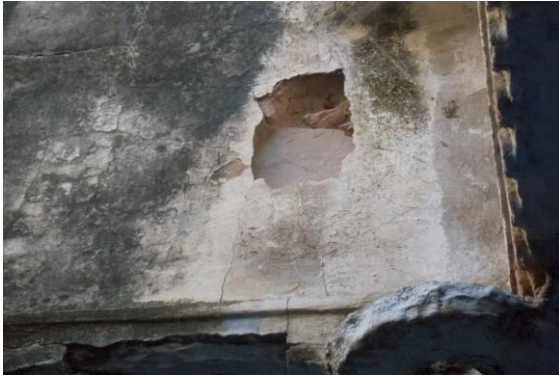
Photo 38

Dampness/Seepage on parapet wall of Sky Open Vrandu-3 of House No. 483, First Floor

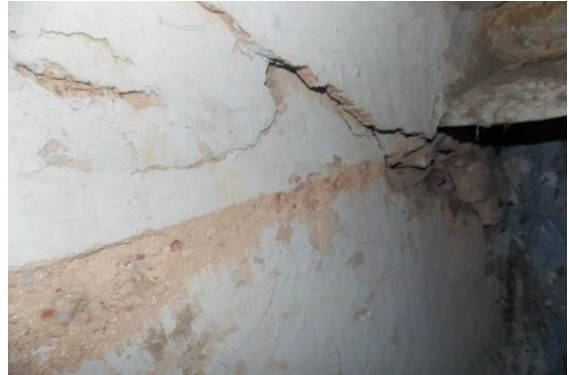
Photo 39

Dampness/Seepage on parapet wall of Stair Case of House No. 483, First Floor

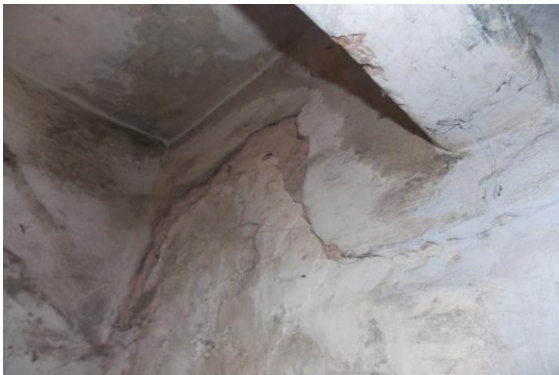
Photo 40

Dampness/Seepage on parapet wall of Stair Case of House No. 483, First Floor

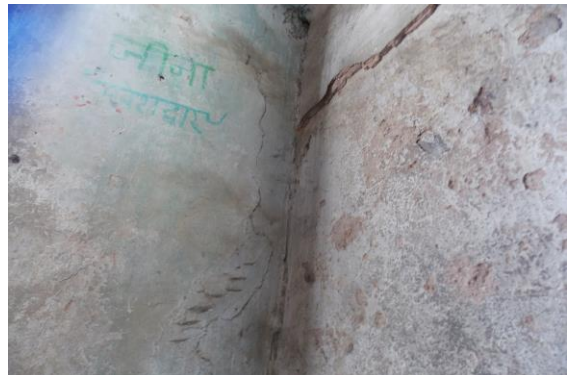
Photo 41

Dampness/Seepage on parapet wall of Stair Case of Second Floor

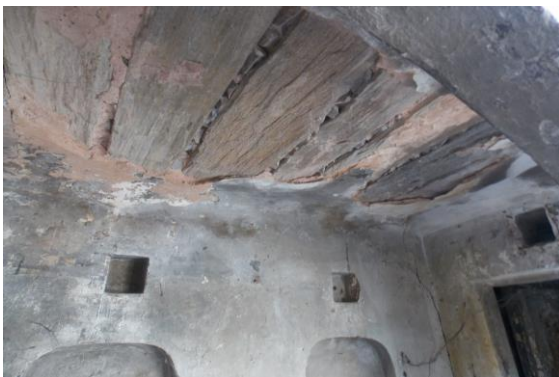
Photo 42

Dampness/Seepage on Lobby2 of House No. 483, Second Floor

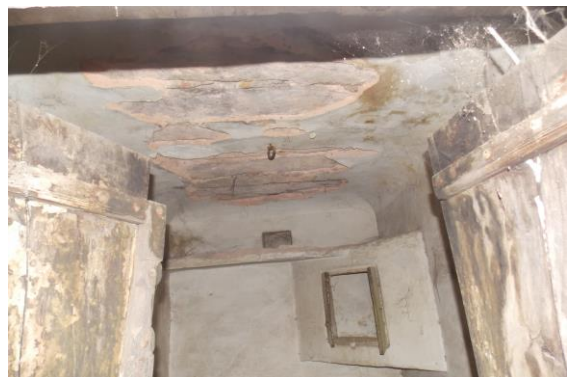
Photo 43

Dampness/Seepage on Room No. 1 of Second Floor

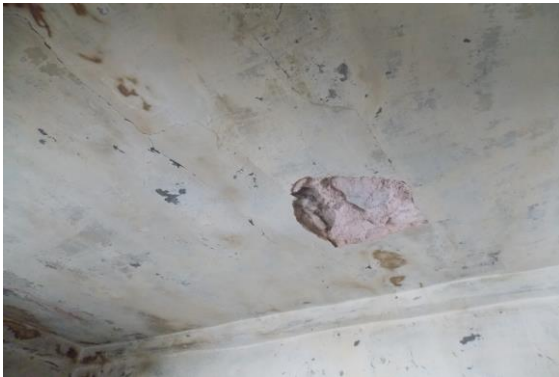
Photo 44

Peeling of Plaster on Roof of Lobby-1 of House No. 483, Second Floor

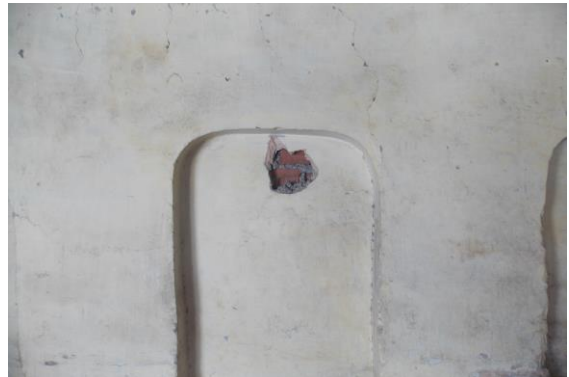
Photo 45

Peeling of Plaster on Roof of Lobby-1 of House No. 483, Second Floor

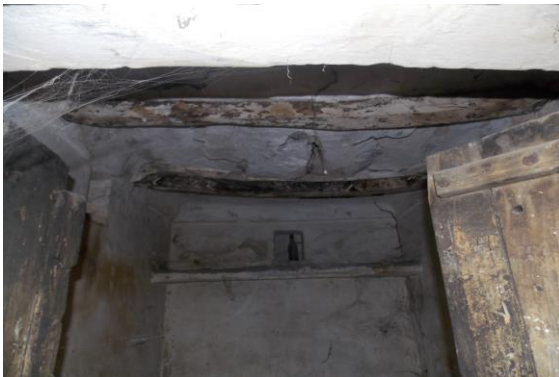
Photo 46

Dampness/Seepage of Room No. 3 of Second Floor

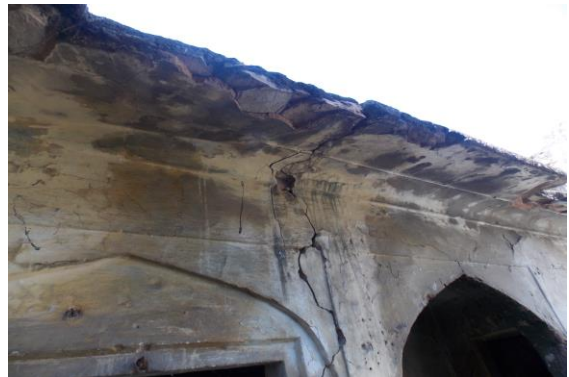
Photo 47

Dampness/Seepage on All Walls & Shade of Open Sky of House No. 483, Second Floor

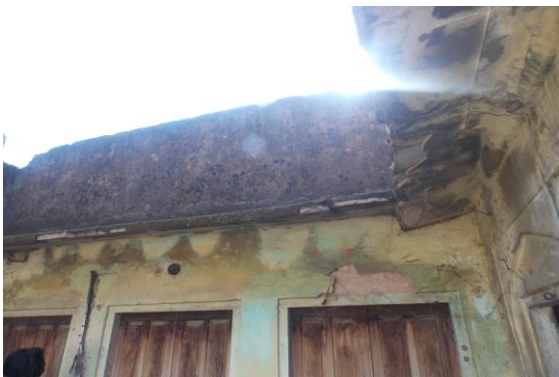
Photo 48

Dampness/Seepage on All Walls & Shade of Open Sky of House No. 483, Second Floor

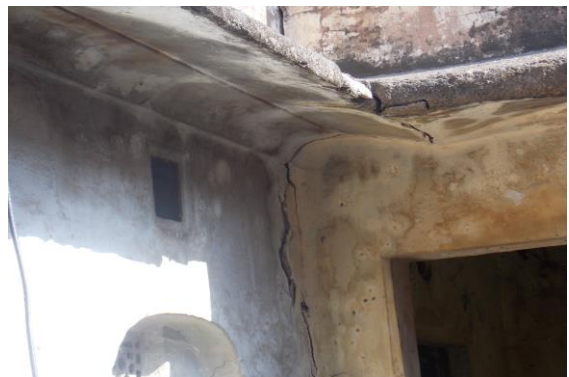
Photo 49

Dampness/Seepage on All Walls & Shade of Open Sky of House No. 483, Second Floor

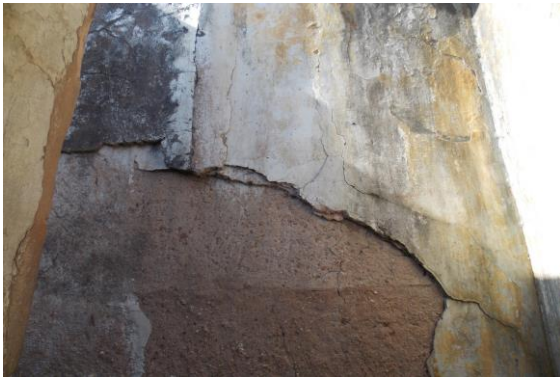
Photo 50

Dampness/Seepage on All Walls & Shade of Stair Case S/F to Terrace of House No. 483, Second Floor

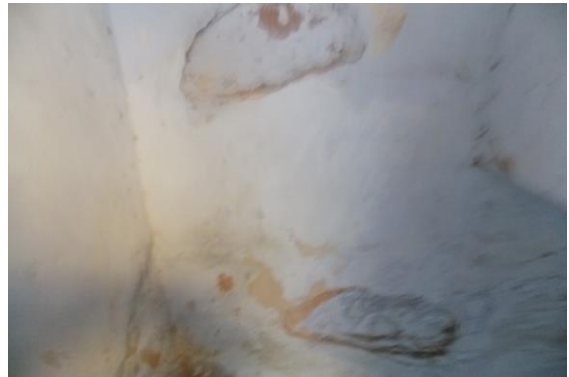
Photo 51

Peeling of Plaster on All Walls & Shade of Stair Case GF to FF of House No. 483, Ground Floor

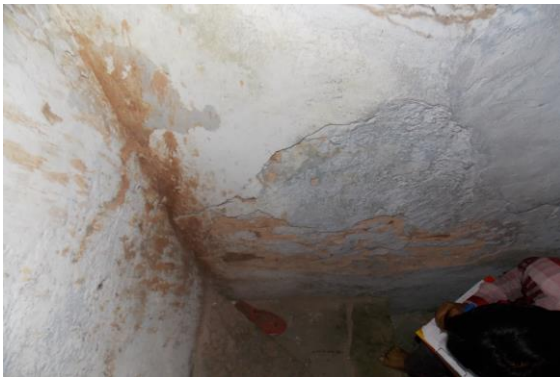
Photo 52

Peeling of Plaster on All Walls & Shade of Stair Case GF to FF of House No. 483, Ground Floor

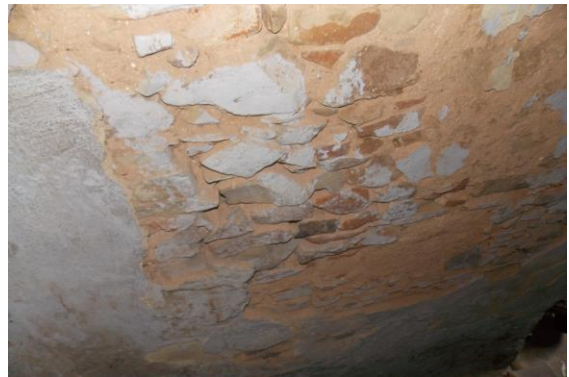
Photo 53

Dampness/Seepage on All Walls & Shade of Stair Case GF to FF of House No. 483, Ground Floor

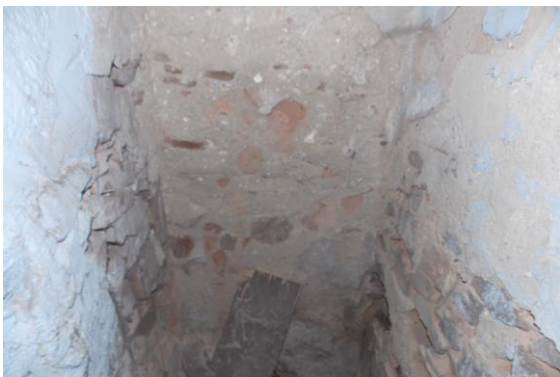
Photo 54

Dampness/Seepage on All Walls & Shade of Stair Case GF to FF of House No. 483, Ground Floor

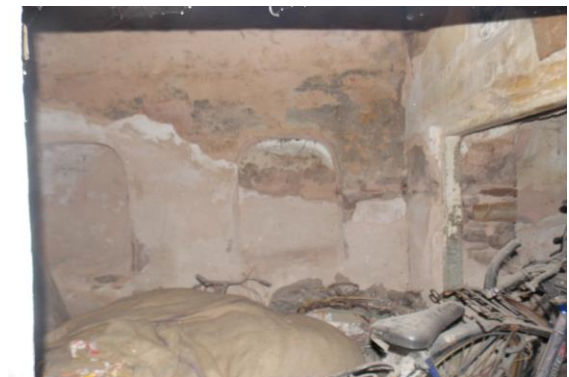
Photo 55

Dampness/Seepage of Room No. 1 & 2 of Ground Floor

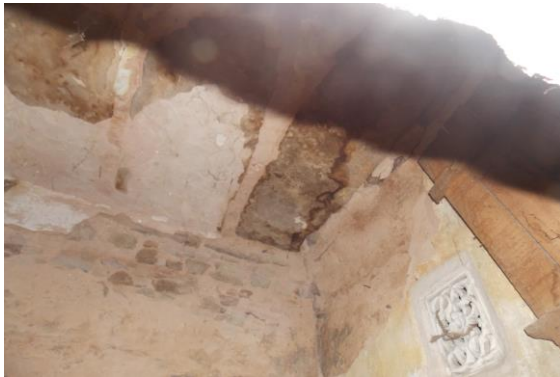
Photo 56
Dampness/Seepage of Room No. 1 & 2 of Ground Floor

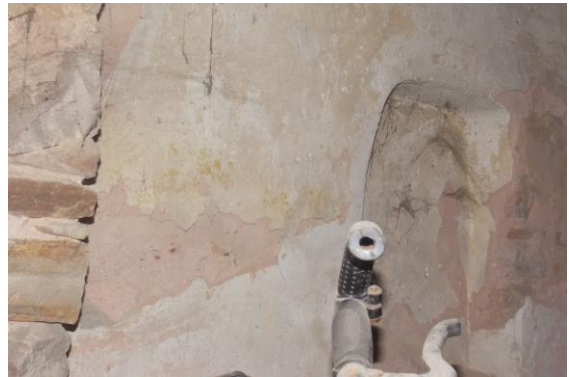
Photo 57
Dampness/Seepage of Room No. 1 & 2 of Ground Floor

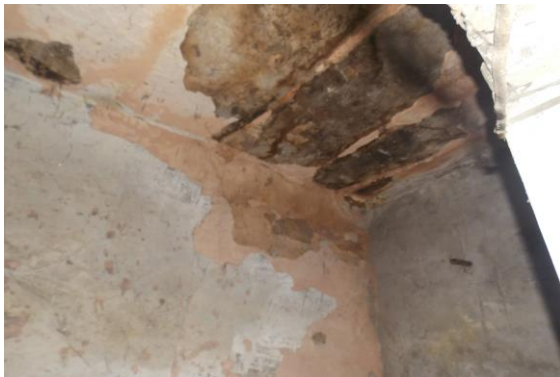
Photo 58
Dampness/Seepage of Room No. 4 of Ground Floor

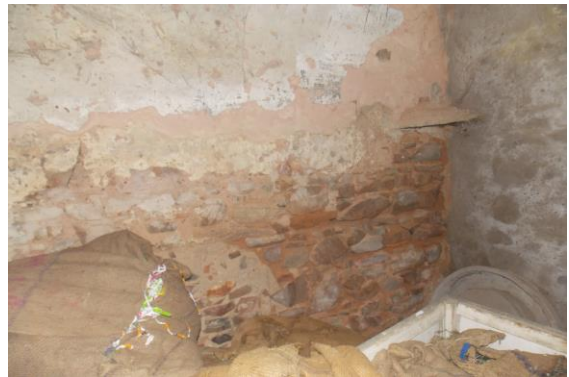
Photo 59
Dampness/Seepage of Room No. 4 of Ground Floor

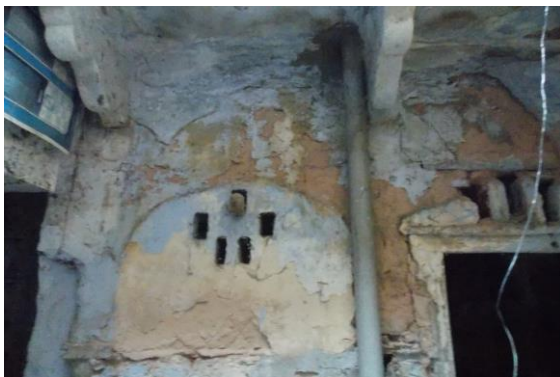
Photo 60
Dampness/Seepage of Sky open of House No. 483, Ground Floor

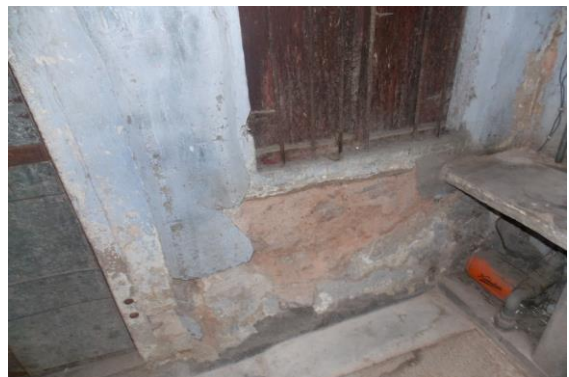
Photo 61
Dampness/Seepage of Sky open of House No. 483, Ground Floor

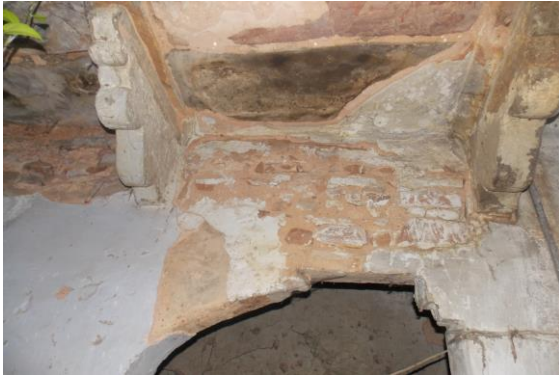
Photo 62
Dampness/Seepage of Sky open of House No. 483, Ground Floor

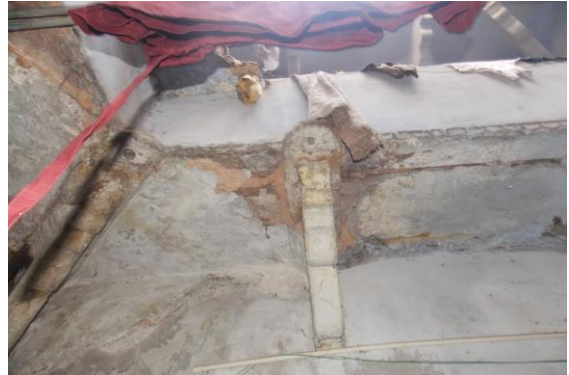
Photo 63
Dampness/Seepage of Sky open Sunshade of House No. 483, Ground Floor

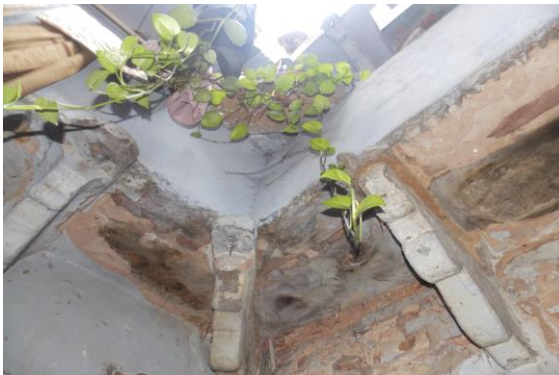
Photo 64
Dampness/Seepage of Sky open Sunshade of House No. 483, Ground Floor

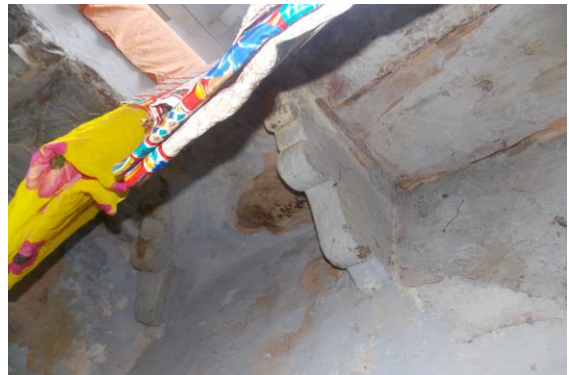
Photo 65
Dampness/Seepage of Sky open Sunshade of House No. 483, Ground Floor

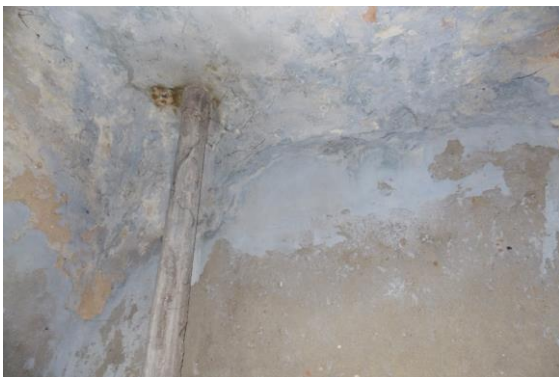
Photo 66
Dampness/Seepage on Roof of Lobby of House No. 483, Ground Floor

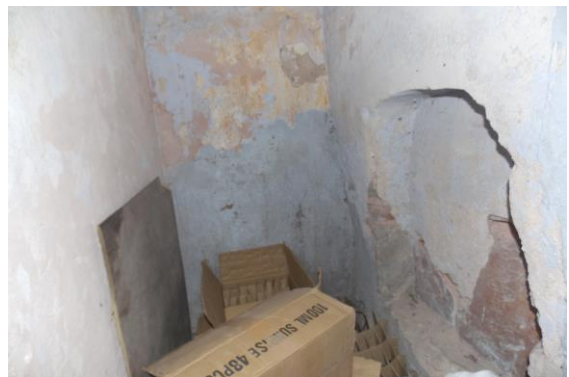
Photo 67
Dampness/Seepage on Roof of Lobby of House No. 483, Ground Floor

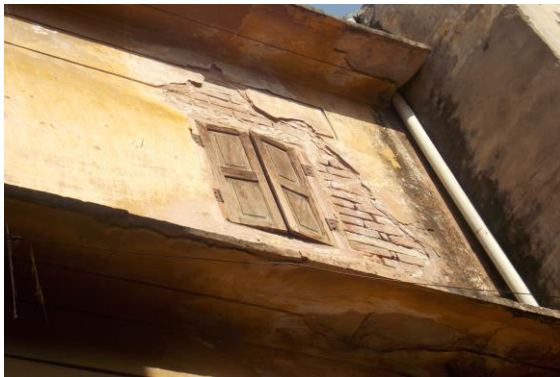
Photo 70

Peeling of Plaster on Back Side of House No. 483, Ground Floor

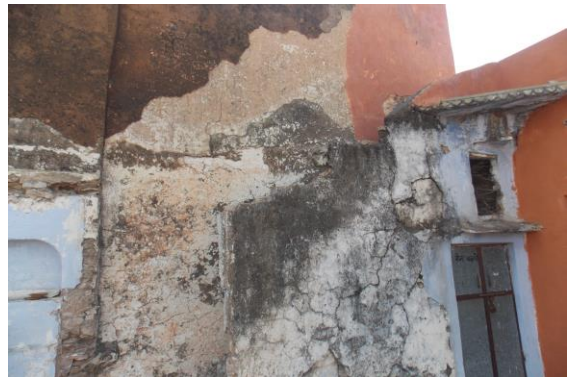
Photo 71

Dampness/Seepage on Back Side of House No. 483, Ground Floor

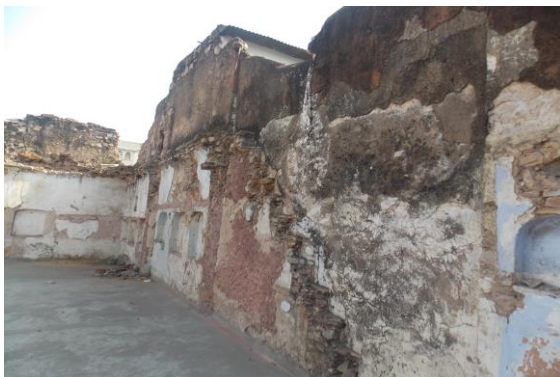
Photo 72

Dampness/Seepage of House No.483 of Ground Floor

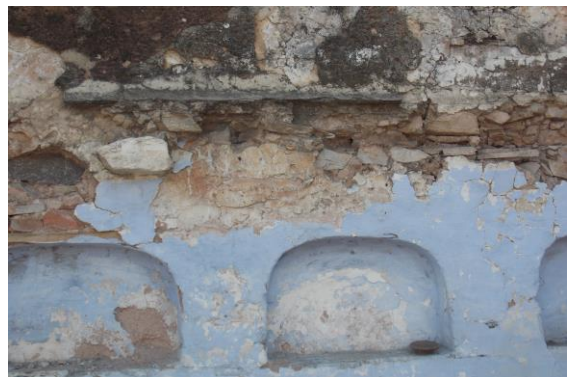
Photo 73

Dampness/Seepage of Main Stair Case of House No. 483, Ground Floor

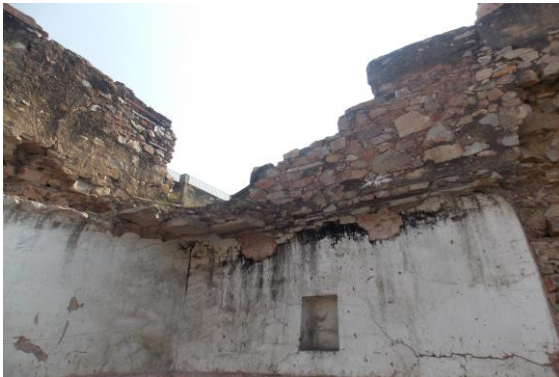
Photo 74

Dampness/Seepage of Main Stair Case of House No. 483, Ground Floor

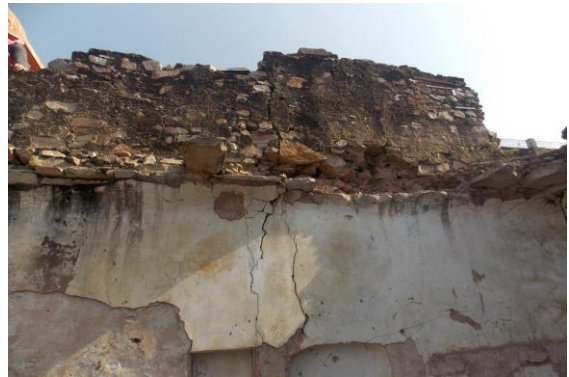
Photo 75

Dampness/Seepage of Main Stair Case of House No. 483, Ground Floor

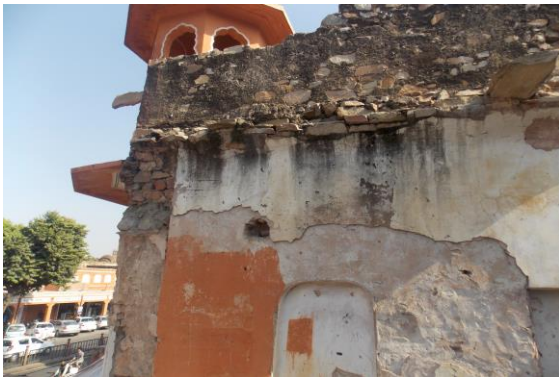
Photo 76

Dampness/Seepage of Main Stair Case of House No. 483, Ground Floor

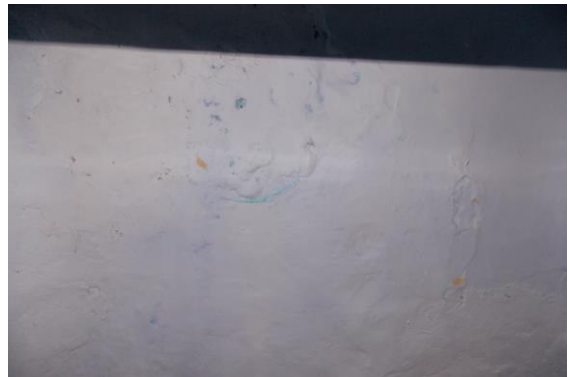
Photo 77

Peeling of Plaster of Main Stair Case of House No. 483, Ground Floor

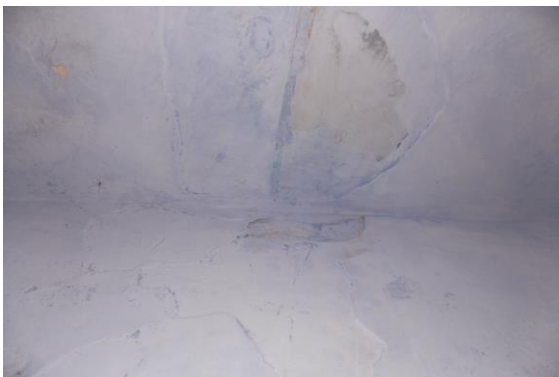
Photo 78

Peeling of Plaster of Store of House No. 483, Ground Floor

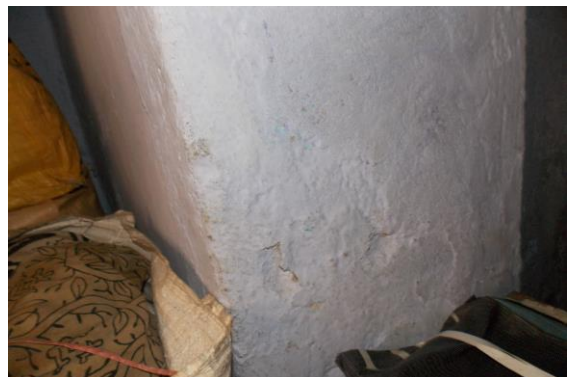
Photo 79

Peeling of Plaster on Roof of Shop-1 of House No. 483, Ground Floor

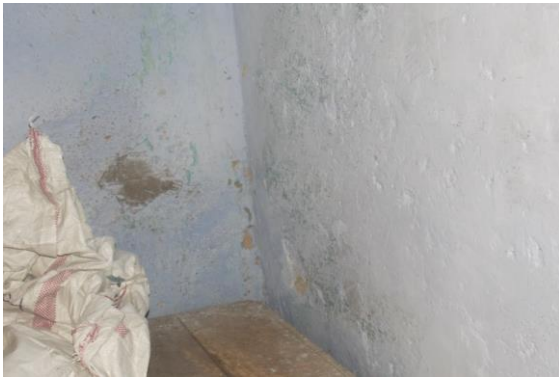
Photo 80

Peeling of Plaster on Wall No.3 & Roof of Shop-1 of House No. 483, Ground Floor

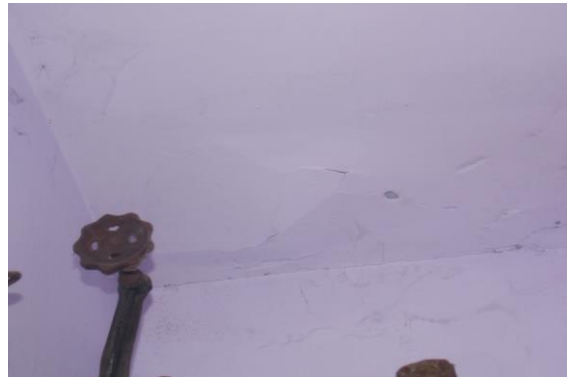
Photo 81

Peeling of Plaster on Wall No.3 & Roof of Shop-1 of House No. 483, Ground Floor

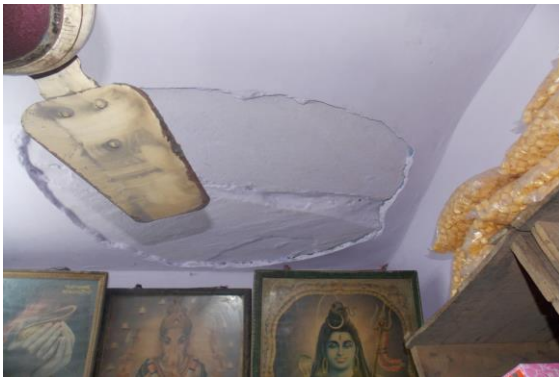
Photo 82

Peeling of Plaster of Shop-1 of House No. 483, Ground Floor

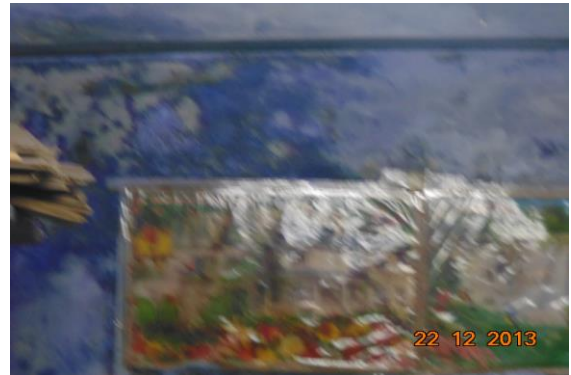
Photo 2
Dampness/Seepage on Wall No. 1 of Hall No. 1 of Ground Floor

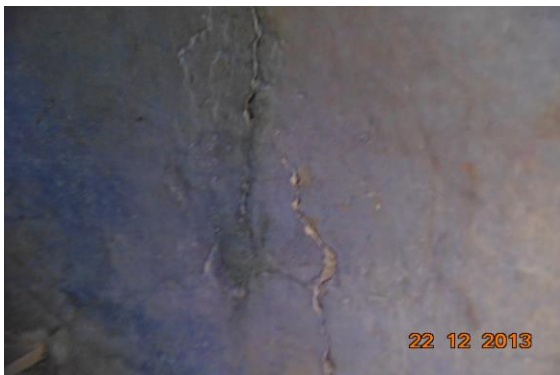
Photo 3
Peeling of Plaster on Open Sky of Ground Floor

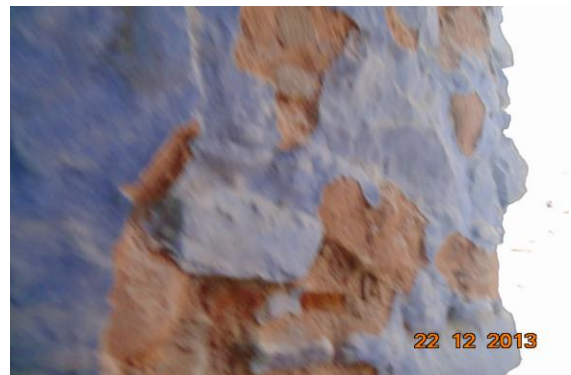
Photo 4
Peeling of Plaster on Wall No. 2 of Staircase GF to FF of Ground Floor

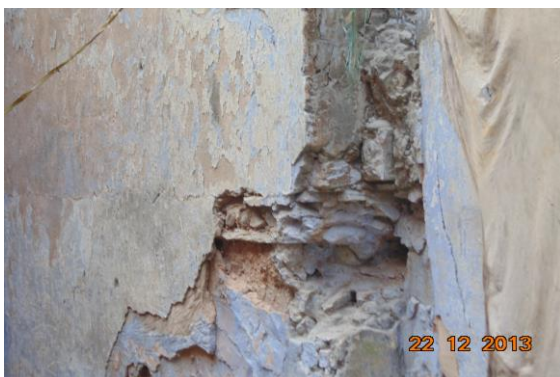
Photo 5
Peeling of Plaster on Wall No. 4 of Open Sky of First Floor

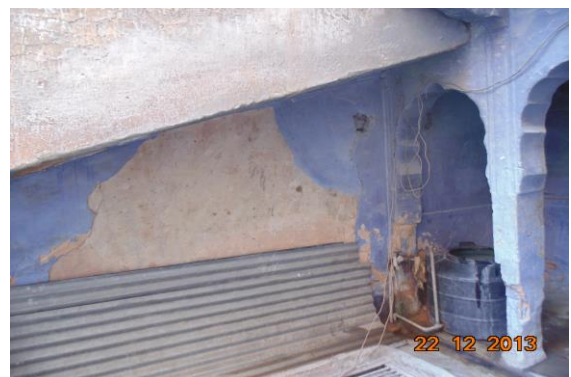
Photo 6
Peeling of Plaster on Wall No. 3 of Open Sky of First Floor

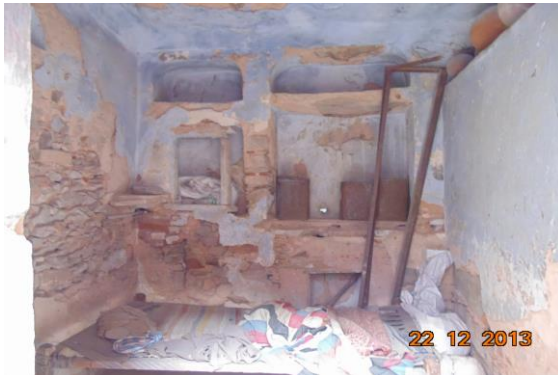
Photo 7
Peeling of Plaster on Room No. 2 of First Floor

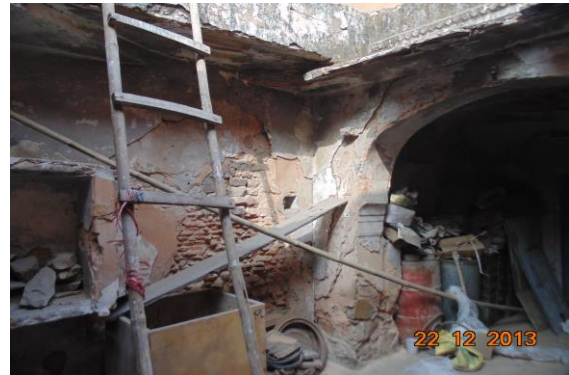
Photo 8
Peeling of Plaster on All Walls of Open Sky Area No.2 of First Floor

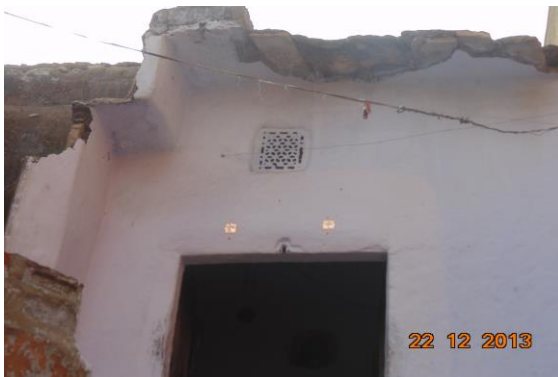
Photo 9
Peeling of Plaster on Roof Shade of of Second Floor

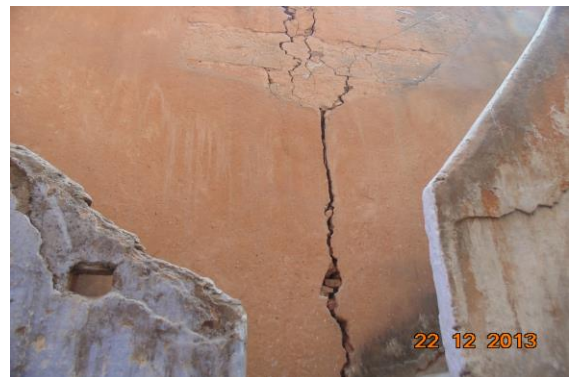
Photo 10
Peeling of Plaster on Staircase FF to SF of Second Floor

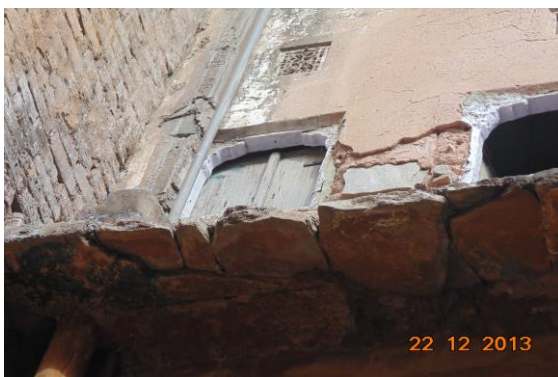
Photo 11
Peeling of Plaster on Outer Wall of Building of Ground Floor
