Pre Building Condition Survey Report

Name and Address of Structure :	Choti Chopar to Badi Chopar (Down Line)
---------------------------------	---

Name of the Project	Contract JMRC-UG1B “Design and Construction of Tunnel between Chandpole and Badi Chouper and reverse line by Shield TBM, Underground Metro Stations at Choti Chouper and Badi Chouper by Cut and Cover Methods on East West Corridor of Jaipur Metro Rail Corporation Limited .”	
Owner :

Pre Building Condition Survey Report Choti Chopar to Badi Chopar (Down Line)

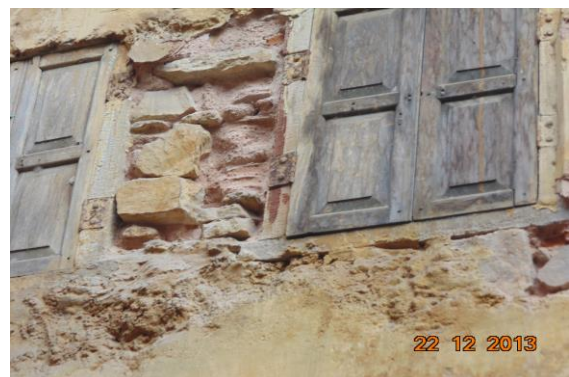
Photo 12
Peeling of Plaster on Outer Wall of Building of Ground Floor

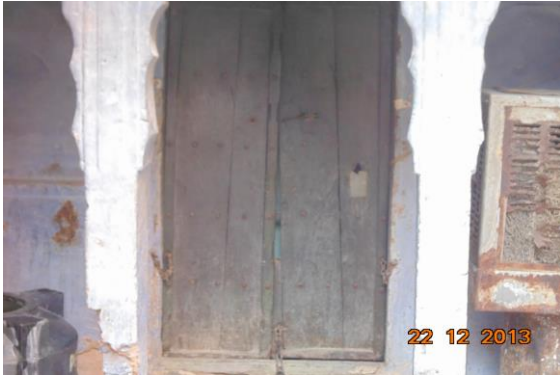
Photo 13

Room No. 1 of First Floor Locked

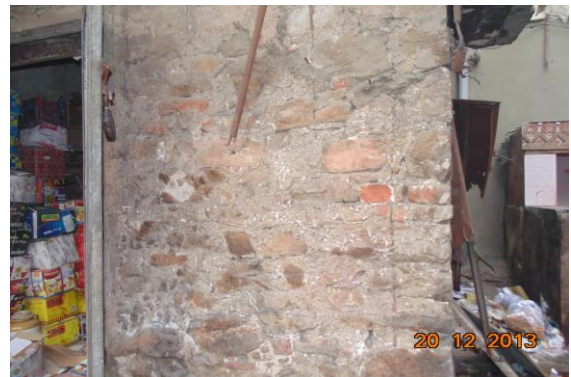
Summary of Defects Other Than Crack			
Defect ID	Location	Description	Photo No.
1	External Façade Building	Peeling of Plaster	4

Photo 4
Peeling of Plaster on External Façade of Building

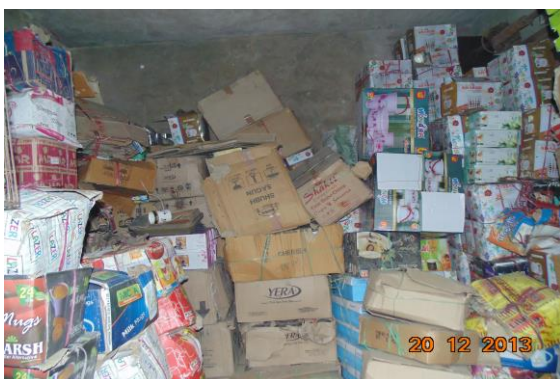
Photo 5
All Walls of Godown No.1 of Ground floor Covered With Material

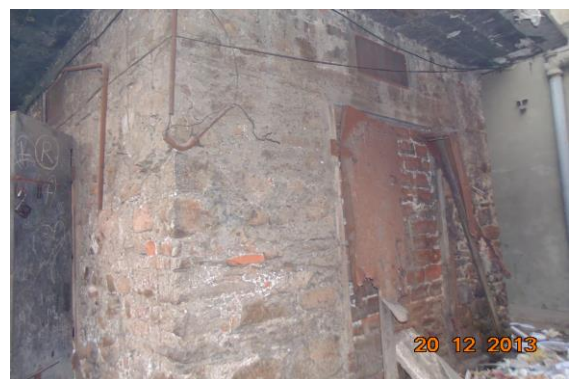
Photo 6
Godown of First Floor Covered With Material

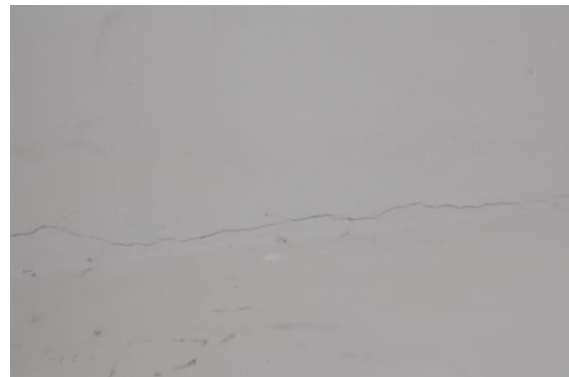
Photo 10
Horizontal Crack on Roof of Room No. 1, Ground Floor
Approx. Width = 0.35mm, Approx. Length = 1.6m.
Distance from Wall no.1 = 0.05m, Height from Floor = 2.5m.

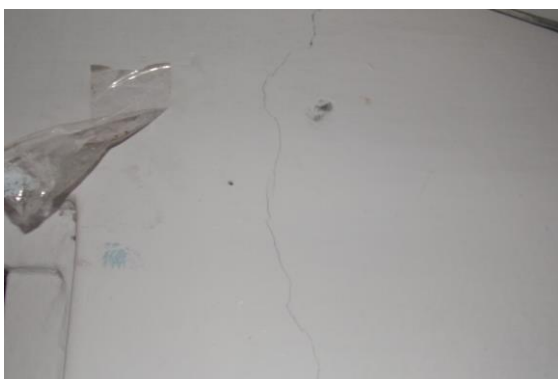
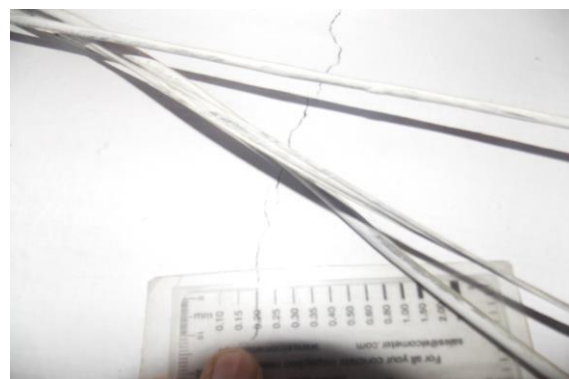
Photo 11
Inclined Crack on Wall No. 3 of Open sky Area, First Floor
Approx. Width = 0.2mm, Approx. Length = 0.5m.
Distance from Wall no.1 = 1.3m, Height from Floor = 1.7m.

Photo 11A
Inclined Crack on Wall No. 3 of Open sky Area, First Floor
Approx. Width = 0.2mm, Approx. Length = 0.5m.
Distance from Wall no.1 = 1.3m, Height from Floor = 1.7m.

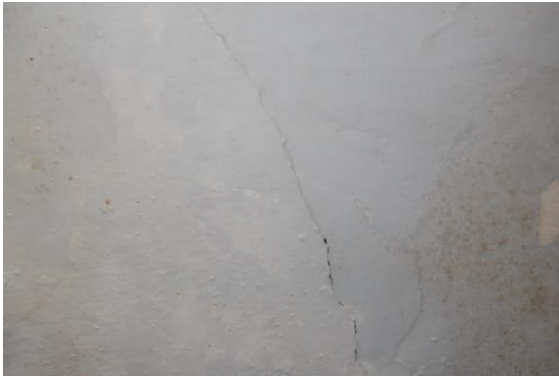
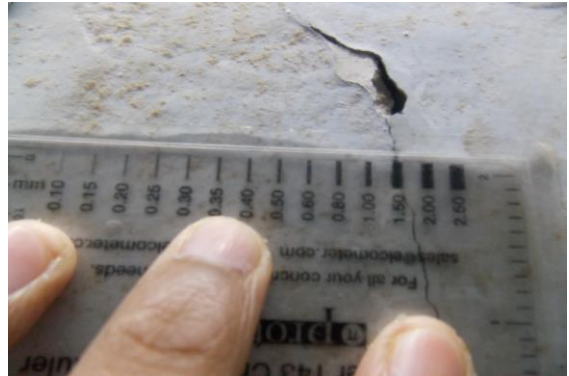
Photo 12

Inclined Crack on Wall No. 4 of Room No. 2, First floor
Approx. Width = 1.5mm, Approx. Length = 2m.
Distance from Wall No.1 = 2m, Height from Floor = 0m.

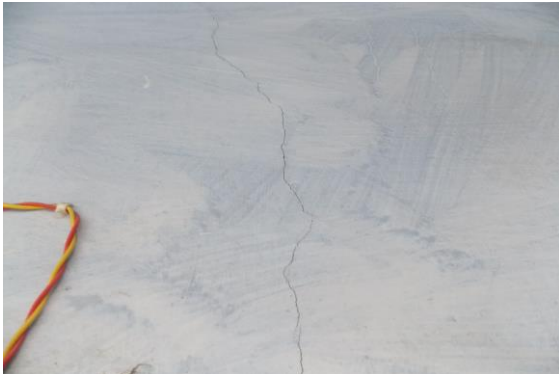
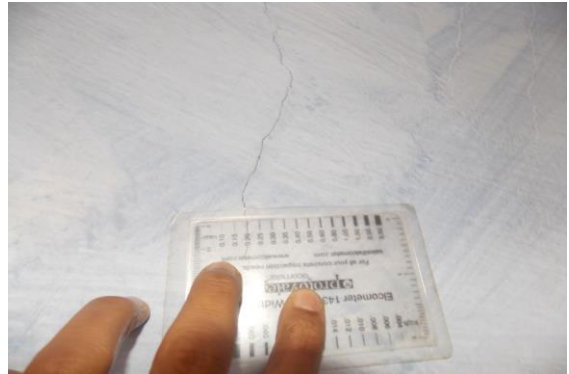
Photo 13

Inclined Crack on Wall No. 3 of Open sky area, Second Floor
Approx. Width = 0.2mm, Approx. Length = 2m.
Distance from = m, Height from Floor = m.

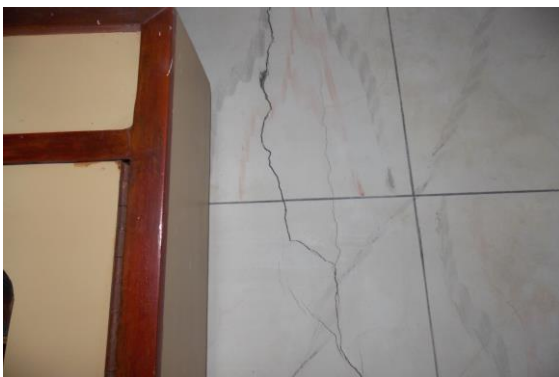
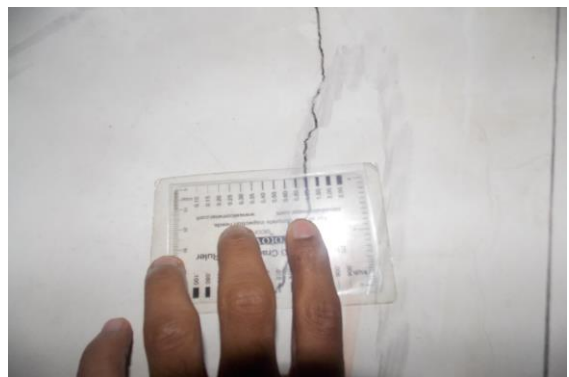
Photo 14

Inclined Crack on Wall No. 2,3, & Roof of Room No. 4, Second Floor
Approx. Width = 1mm, Approx. Length = 3.8m. Distance from Wall no.1
= 1.1m, Height from Floor = 1m.

Inclined Crack on Wall No. 2, 3, & Roof of Room No. 4, Second Floor
Approx. Width = 1mm, Approx. Length = 3.8m. Distance from Wall no.1
= 1.1m, Height from Floor = 1m.

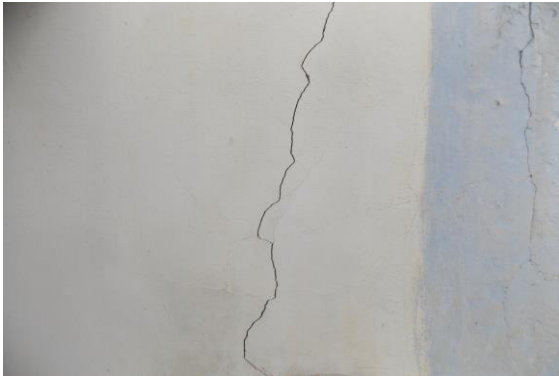
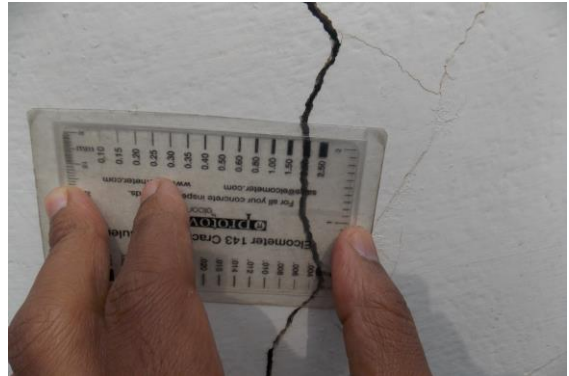
Photo 15

Inclined Crack on Wall No. 1 of Open sky area, Second Floor Approx.
Width = 2mm, Approx. Length = 2m. Distance from Wall No.4 = 0.25m,
Height from Floor = 0m.

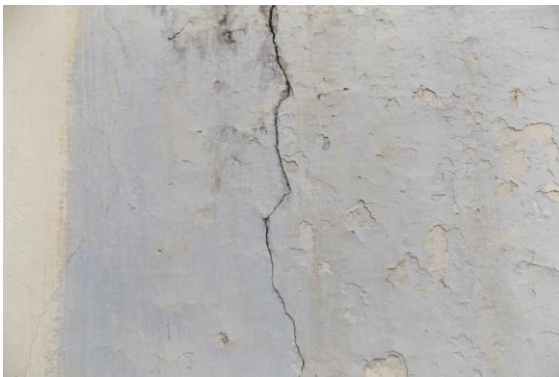
Photo 16

Inclined Crack on Wall No. 1 of Open sky area, Second Floor Approx.
Width = 2.5mm, Approx. Length = 1m. Distance from Wall no.4 = 0.5m,
Height from Floor = 1.2m.

Inclined Crack on Wall No. 1 of Open sky area, Second Floor Approx.
Width = 2.5mm, Approx. Length = 1m.
Distance from Wall no.4 = 0.5m, Height from Floor = 1.2m.

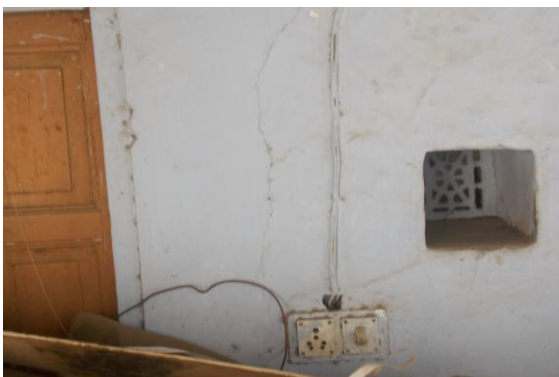
Photo 17

Inclined Crack on Wall No. 4 of Open sky area, Second Floor
Approx. Width = 0.2mm, Approx. Length = 1.2m.
Distance from Wall no.1 = 1.3m, Height from Floor = 1m.

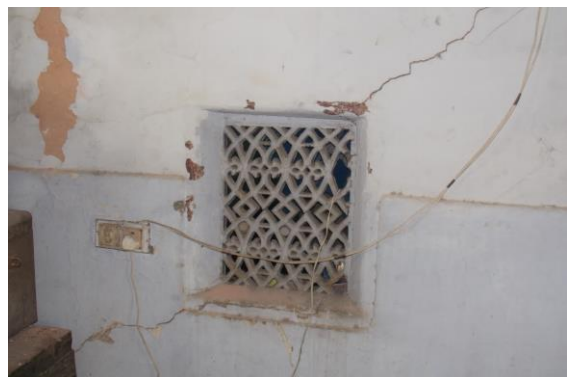
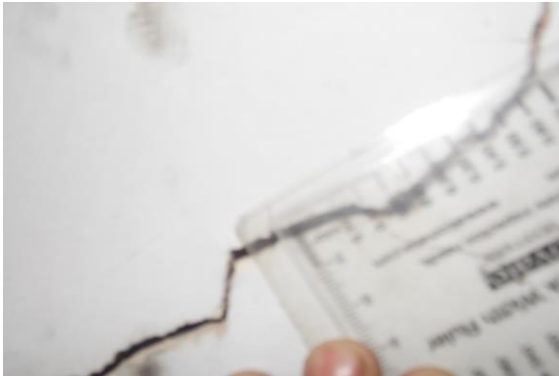
Photo 18

Inclined Crack on Wall No. 2 of Room No. 3, Second Floor
Approx. Width = 4mm, Approx. Length = 2.5m.
Distance from Wall no.3 = 0m, Height from Floor = 0m.

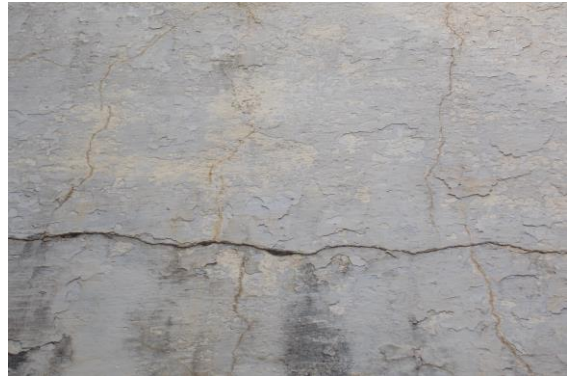
Photo 19

Horizontal Crack on Wall No. 3 & Roof Shade of House no.410,
Approx. Width = 0.35mm, Approx. Length = 1.5m.
Distance from Wall no.1 = 1.5m, Height from Floor = 2m.

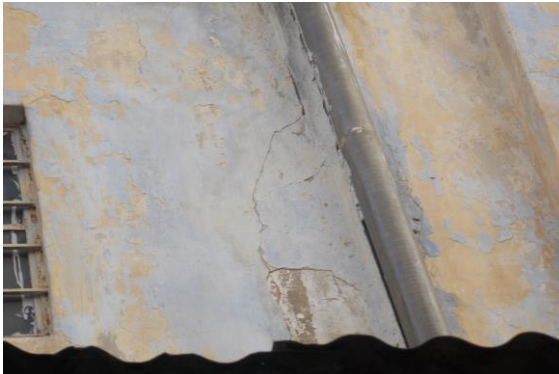
Photo 20

Inclined Crack on Front side Wall of House no.410, First Floor
Approx. Width = 0.35mm, Approx. Length = 1.5m.
Distance from Left side wall = 2m, Height from Floor = 4m.

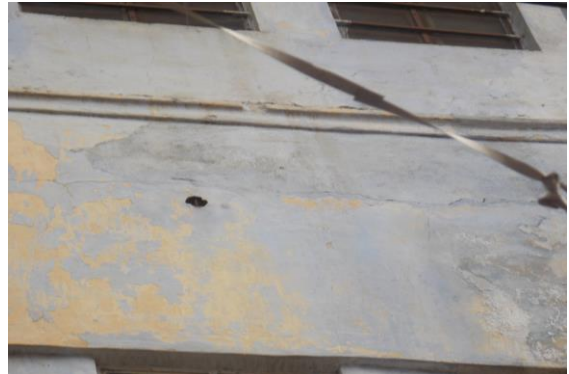
Photo 21

Inclined Crack on Front side Wall of House no.410, First floor
Approx. Width = 0.6mm, Approx. Length = 2.8m.
Distance from Left side wall = 2.1m, Height from Floor = 5.5m.

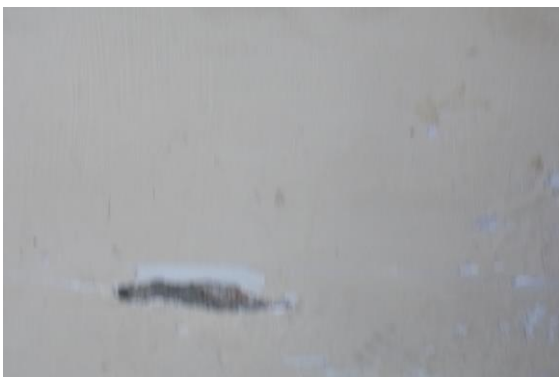
Photo 22

Peeling of Plaster on Wall No. 1 Passage of Ground Floor

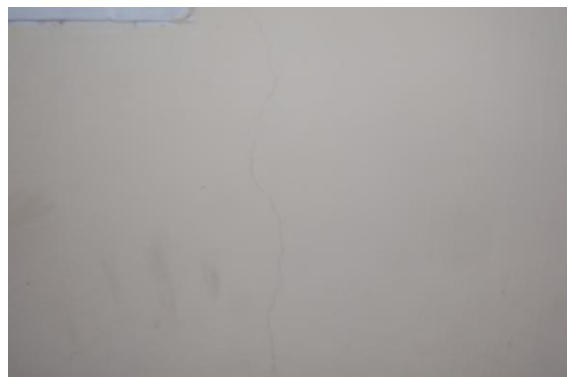
Photo 23

Peeling of Plaster on Wall No. 1 of Passage of Ground Floor

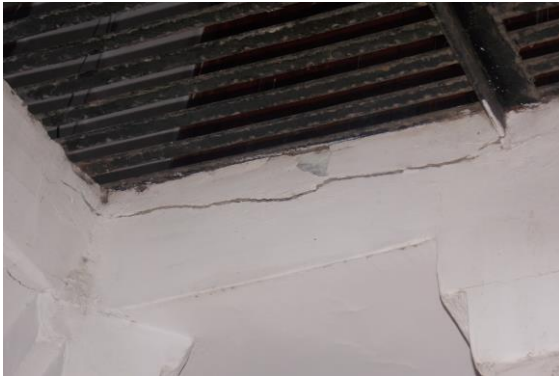
Photo 24

Peeling of Plaster on Wall No. 4 of Open skyCourtyard Mumty of Ground Floor

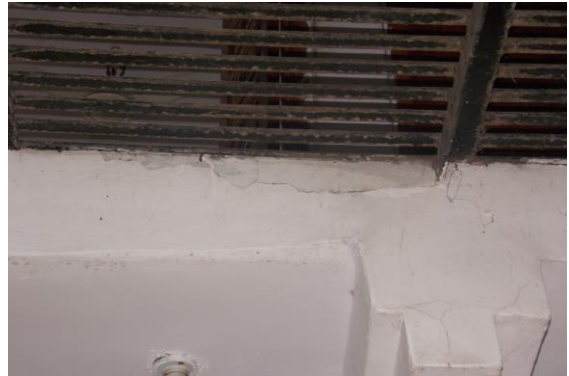
Photo 25

Peeling of Plaster on Wall No. 4 of Open skyCourtyard Mumty of Ground Floor

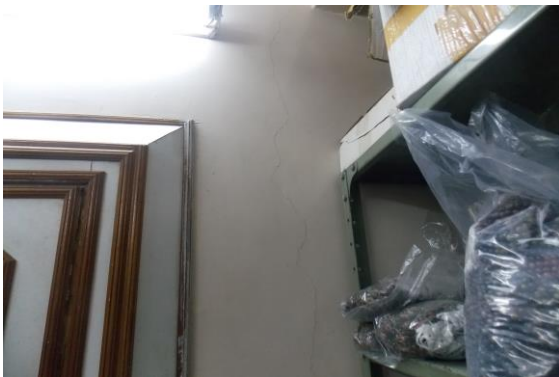
Photo 26

Peeling of Plaster on Wall No. 5 of Hall No. 1 of Ground Floor

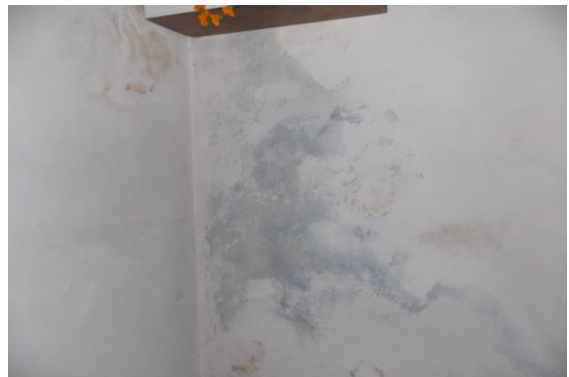
Photo 27

Dampness/Seepage on Wall No. 2 & 4 of Room No. 3 of Ground Floor

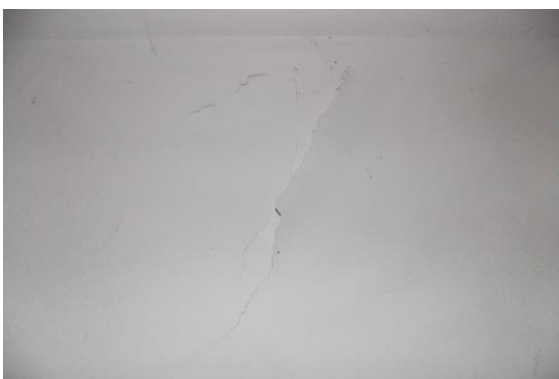
Photo 28

Peeling of Plaster on Wall No. 1 of House No.410 of

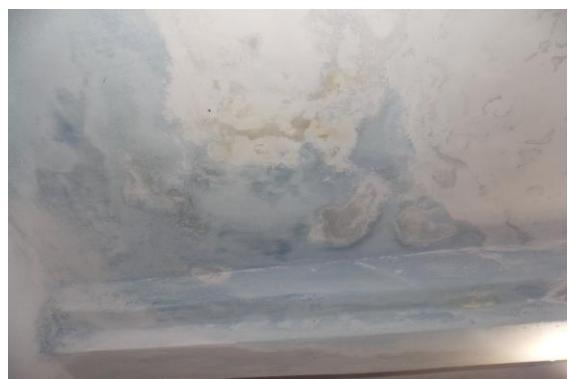
Photo 29

Dampness/Seepage on Roof of Toilet No. 1 of First Floor

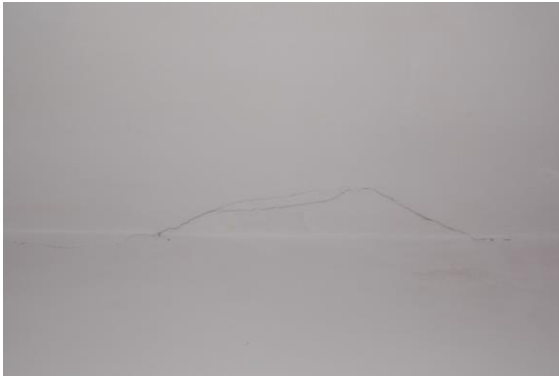
Photo 30
Peeling of Plaster on Roof of Room No. 1 of First Floor

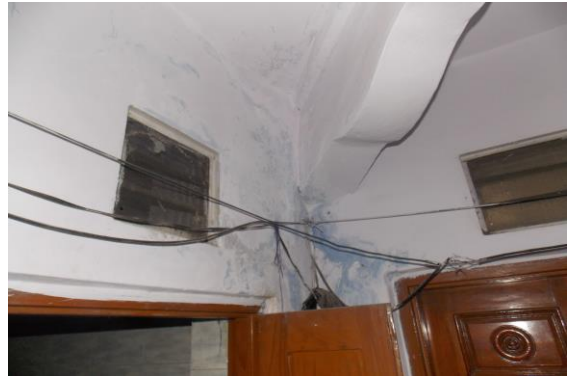
Photo 31
Dampness/Seepage on Wall No. 3 & 1 of Open sky Area of First Floor

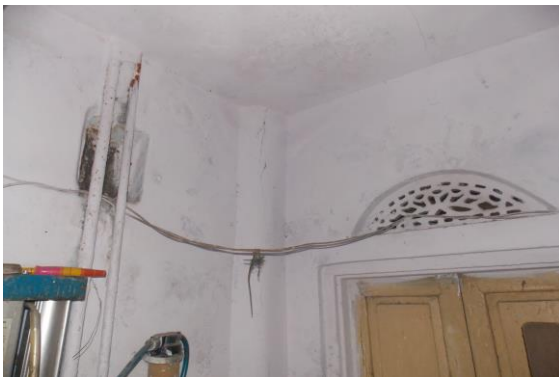
Photo 32
Dampness/Seepage on Wall No. 2 & 4 of Open sky area of First floor

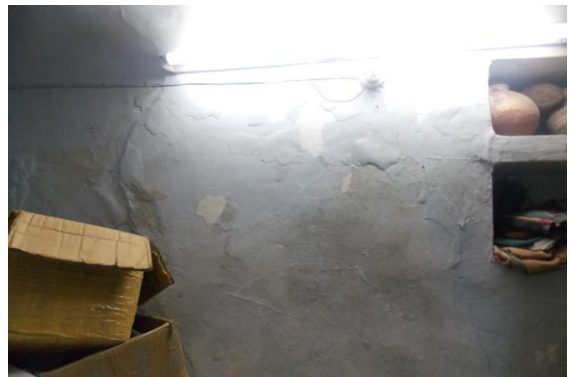
Photo 33
Peeling of Plaster on Wall No. 4 of Room No. 2 of First floor

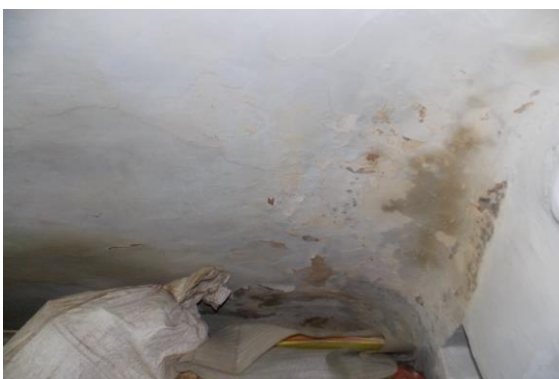
Photo 34
Dampness/Seepage on Roof of Room No. 2 of First floor

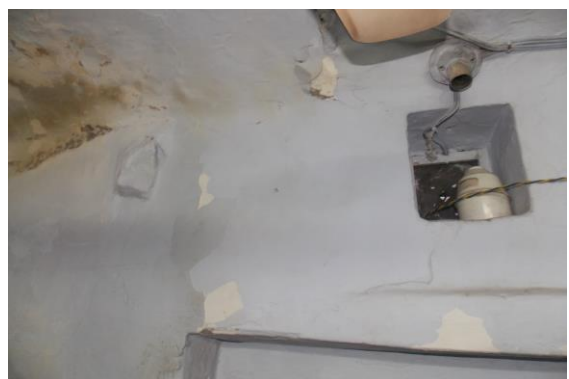
Photo 35
Peeling of Plaster on Wall No. 3 of Room No. 2 of First floor

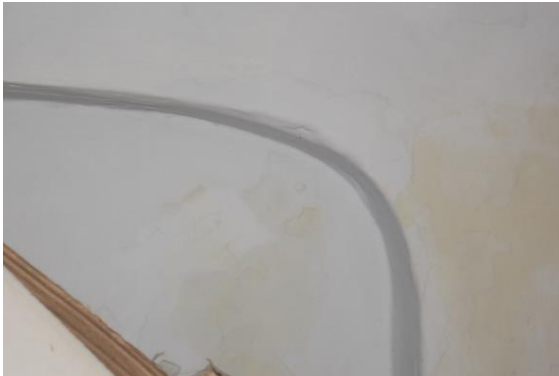
Photo 36
Dampness/Seepage on Wall No. 1 of Room No. 2 of First floor

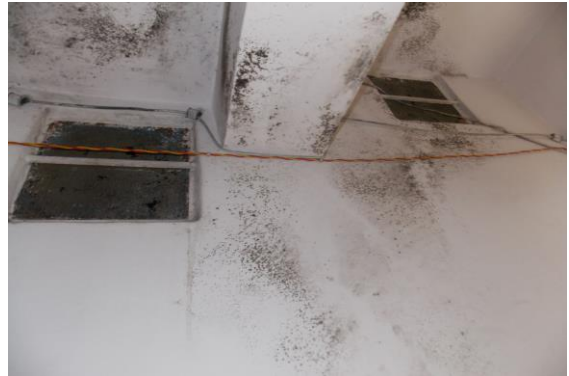
Photo 37
Dampness/Seepage on Wall No.4 & Roof of Staircase FF to SF of First floor

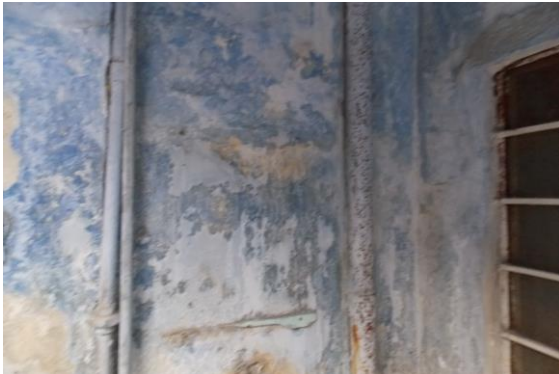
Photo 38
Peeling of Plaster on Wall No. 4 & 2 of Open sky Area of First floor

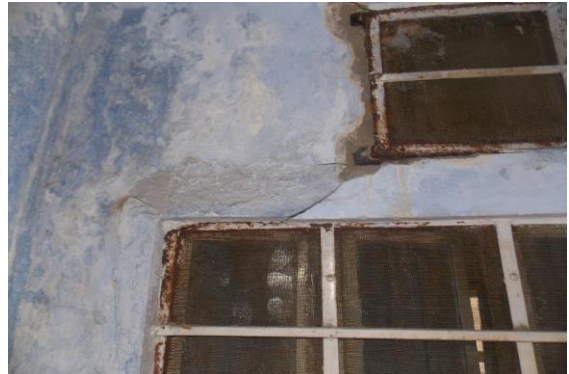
Photo 39
Peeling of Plaster on Wall No. 2 of Open sky area of First floor

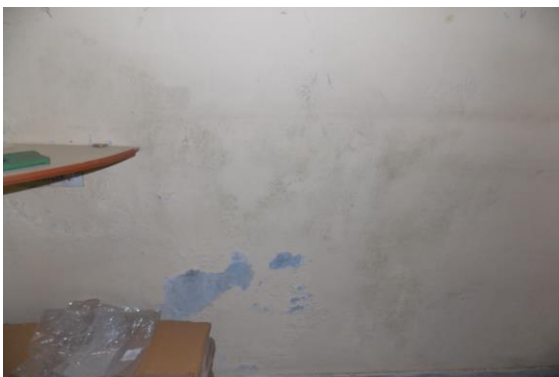
Photo 40
Dampness/Seepage on Wall No. 1 of Room No. 1 of Second Floor

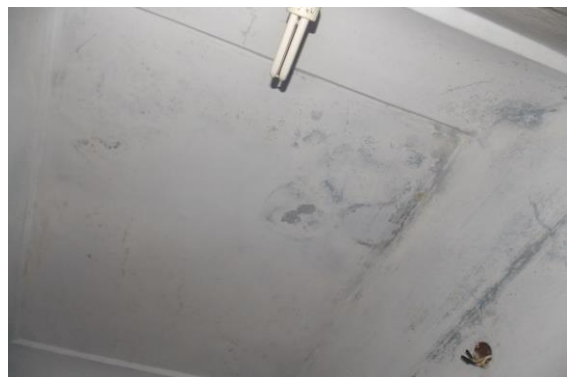
Photo 41
Dampness/Seepage on Roof of Toilet No. 1 of Second Floor

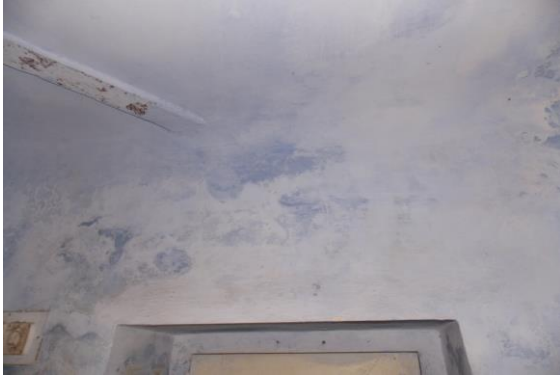
Photo 42

Dampness/Seepage on Wall No. 2 & Roof of Bathroom of Second Floor

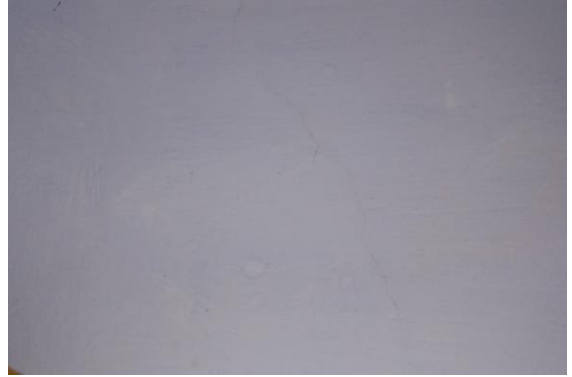
Photo 43

Peeling of Plaster on Wall No. 4 of Bathroom of Second Floor

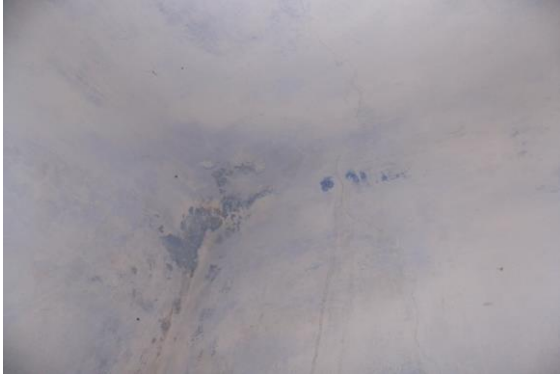
Photo 44

Dampness/Seepage on Wall No. 3 & Roof of Bathroom No. of Second Floor

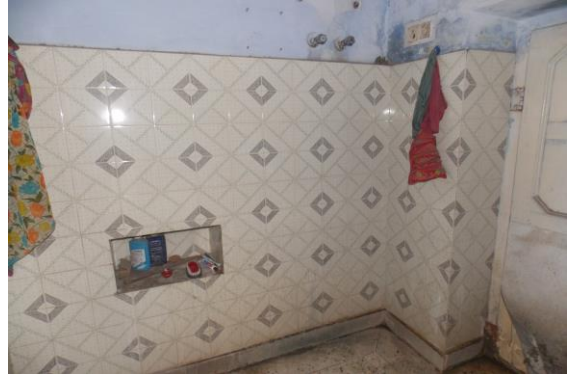
Photo 45

Peeling of Plaster on All walls of Bathroom No. of Second Floor

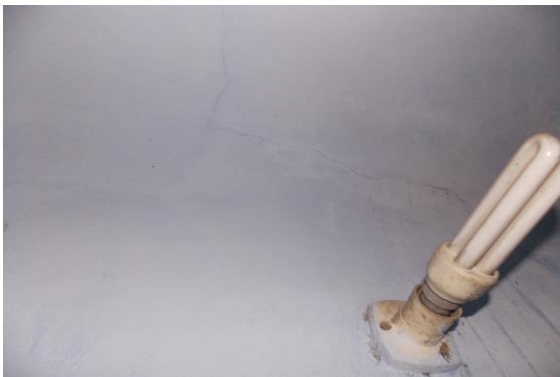
Photo 46

Peeling of Plaster on Wall No. 3 & Roof of Toilet No. 1 of Second Floor

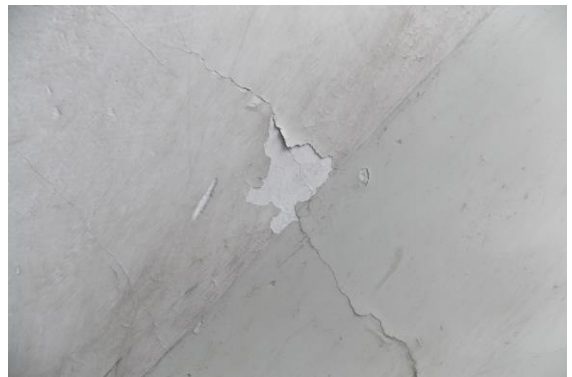
Photo 47

Peeling of Plaster on Staircase SF to TF of Second Floor

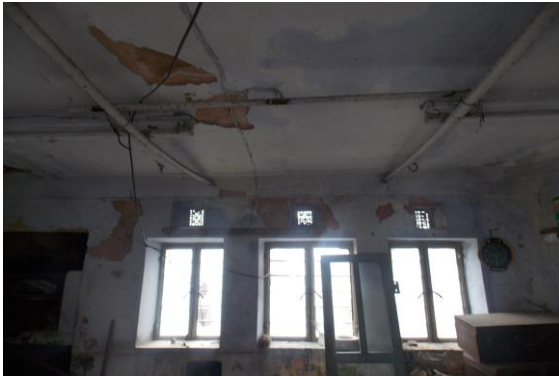
Photo 48

Peeling of Plaster on Wall No. 4 & Roof of Room No. 3 of Second Floor

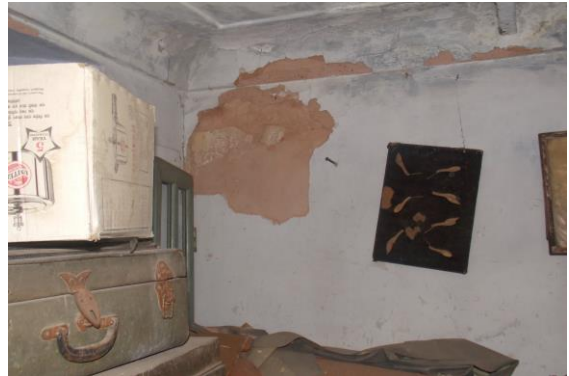
Photo 49

Peeling of Plaster on Wall No. 1 of Room No. 3 of Second Floor

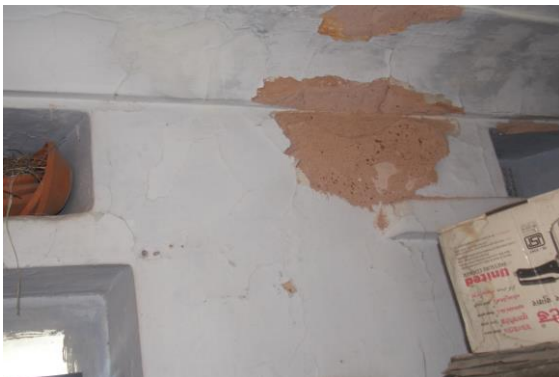
Photo 50

Peeling of Plaster on Wall No. 3 of Room No. 3 of Second Floor

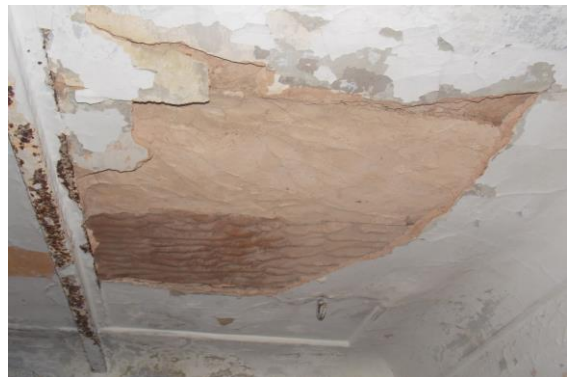
Photo 51

Peeling of Plaster on Roof of Room No. 3 of Second Floor

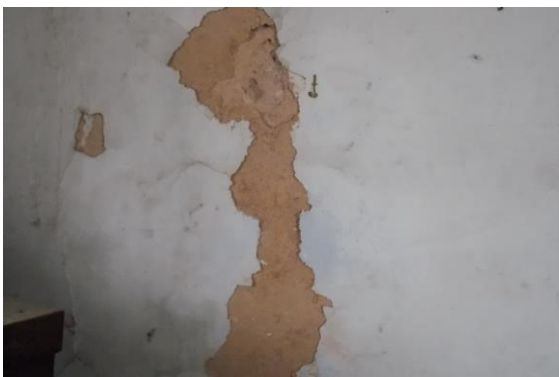
Photo 52

Peeling of Plaster on Wall No. 2 of Room No. 3 of Second Floor

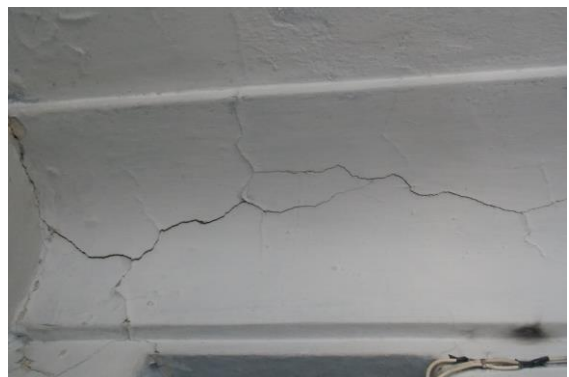
Photo 53

Peeling of Plaster on Roof of Room No. 3 of Second Floor

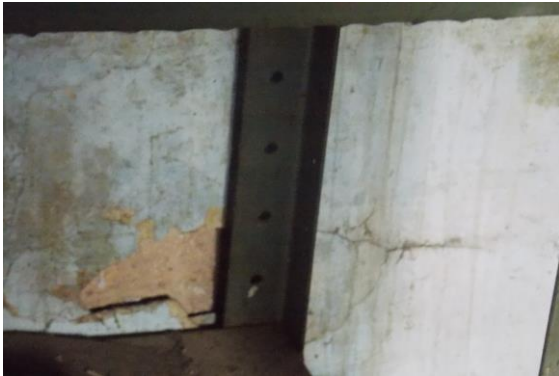
Photo 54

Peeling of Plaster on Wall No. 4 of Room No. 4 of Second Floor

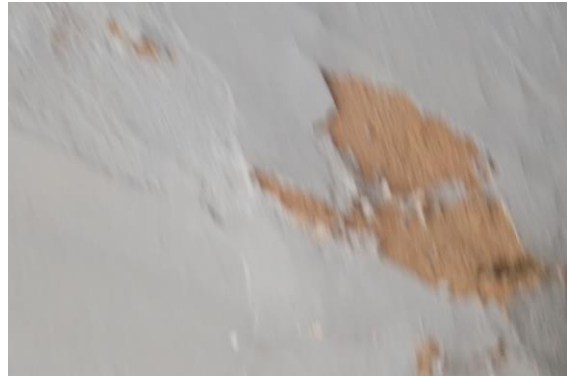
Photo 55

Peeling of Plaster on Wall No. 1 of Room No. 4 of Second Floor

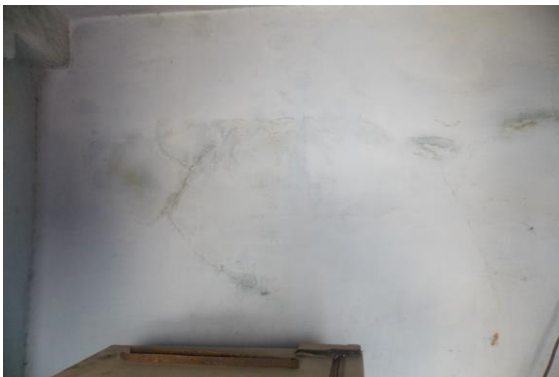
Photo 56

Dampness/Seepage on Wall No. 4 of Room No. 2 of Second Floor

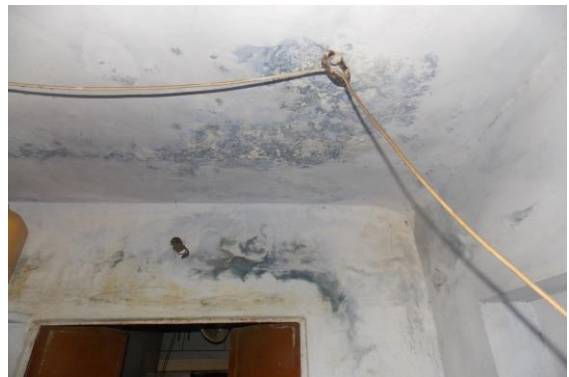
Photo 57

Dampness/Seepage on Wall No. 2 & Roof of Room No. 2 of Second Floor

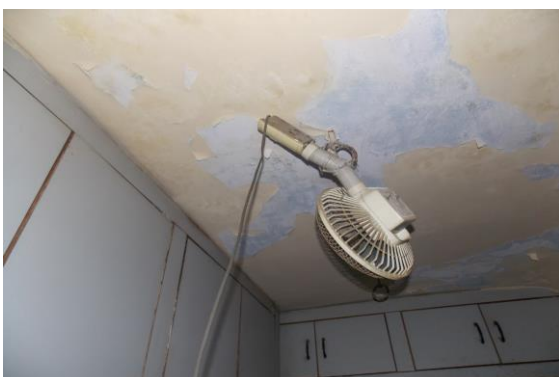
Photo 58

Peeling of Plaster on Roof of Kitchen of Second Floor

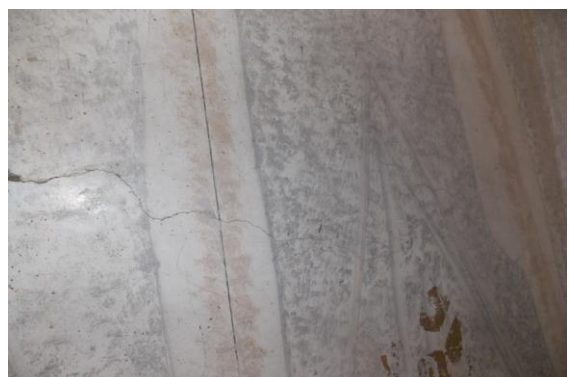
Photo 59

Peeling of Plaster on Wall No. 1 of Room No. 1 of Second Floor

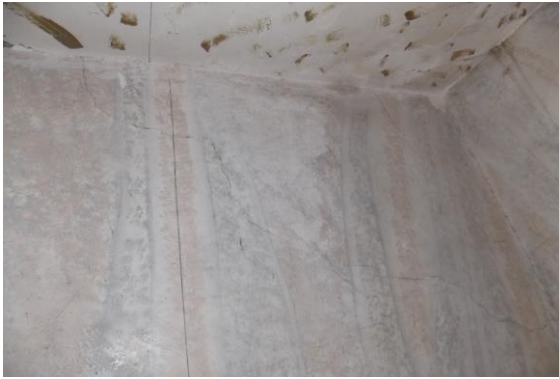
Photo 60

Peeling of Plaster on Wall No. 1 of Room No. 1 of Second Floor

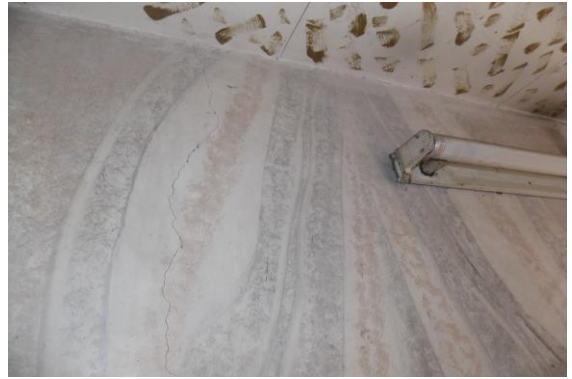
Photo 61

Peeling of Plaster on Wall No. 4 of Room No. 1 of Second Floor

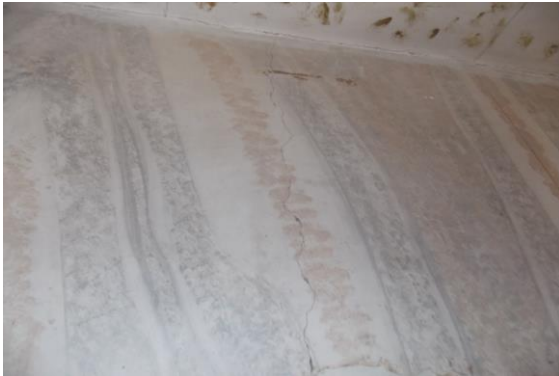
Photo 62

Peeling of Plaster on Wall No. 4 of Room No. 1 of Second Floor

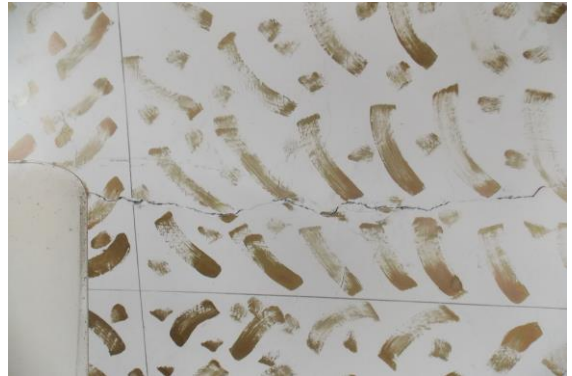
Photo 63

Peeling of Plaster on Roof of Room No. 1 of Second Floor

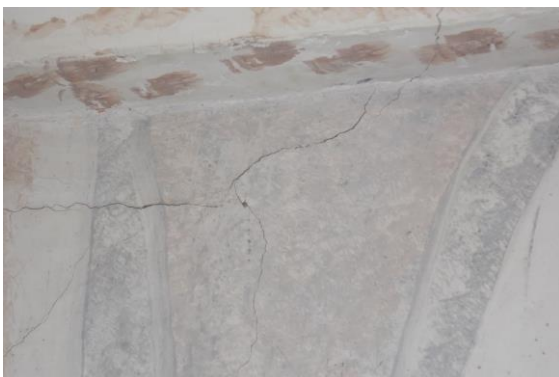
Photo 64

Peeling of Plaster on Wall No. 2 of Room No. 1 of Second Floor

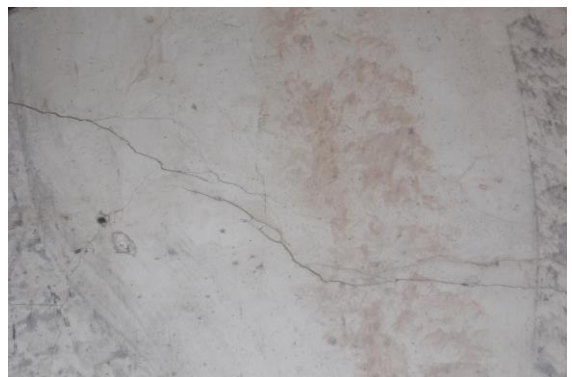
Photo 65

Peeling of Plaster on Wall No. 3 of Room No. 1 of Second Floor

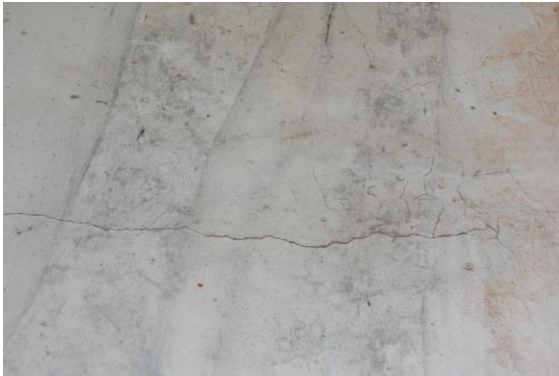
Photo 66
Peeling of Plaster on Wall No. 3 of House no.410 of Second Floor

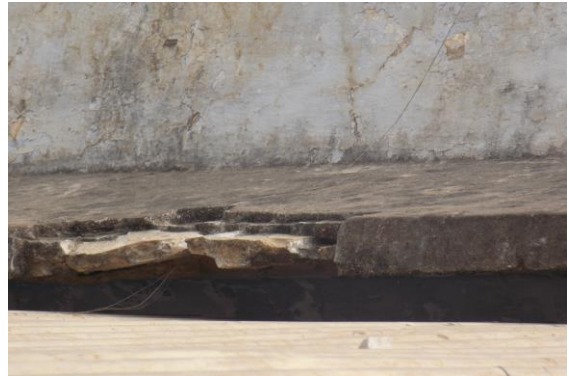
Photo 67
Peeling of Plaster on Wall No.4 & Roof Shade of House no.410 of Second Floor

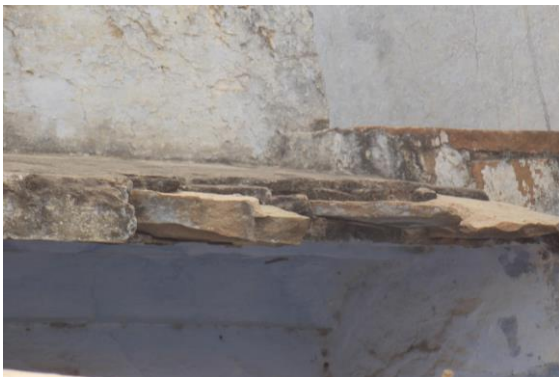
Photo 68
Peeling of Plaster on Wall No. 4 & Roof Shade of House no.410 of Second Floor

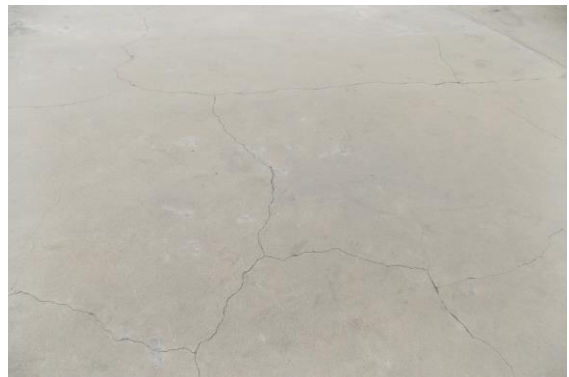
Photo 69
Peeling of Plaster on Floor of House no.410 of Terrace No.1

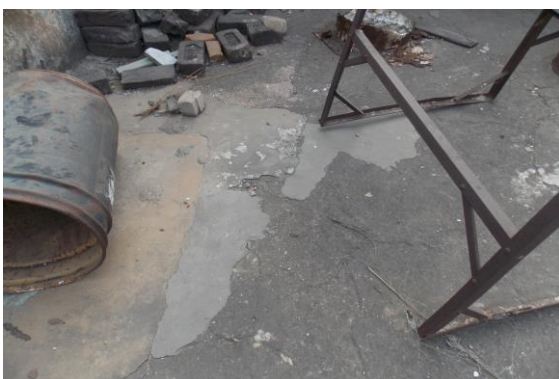
Photo 70
Peeling of Plaster on Floor of House no.410 of Terrace No.2

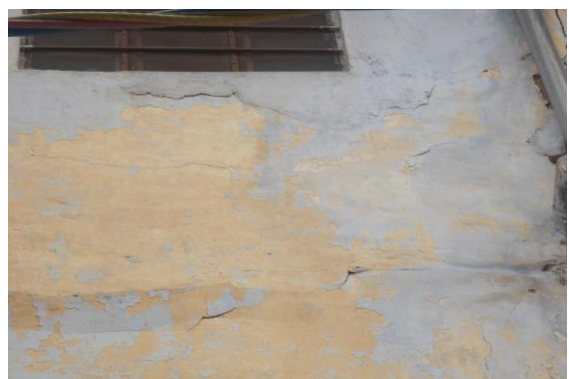
Photo 71
Peeling of Plaster on Front side Wall of House no.410 of Ground Floor

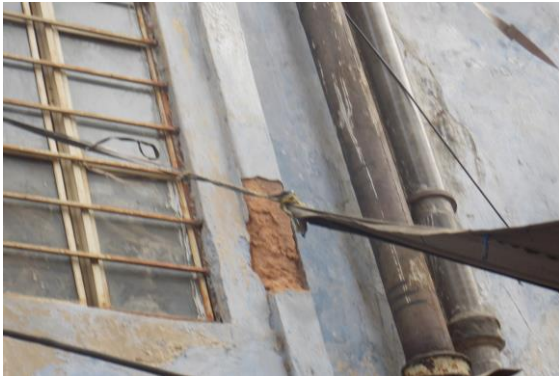
Photo 72

Peeling of Plaster on Front side Wall of House no.410 of First floor

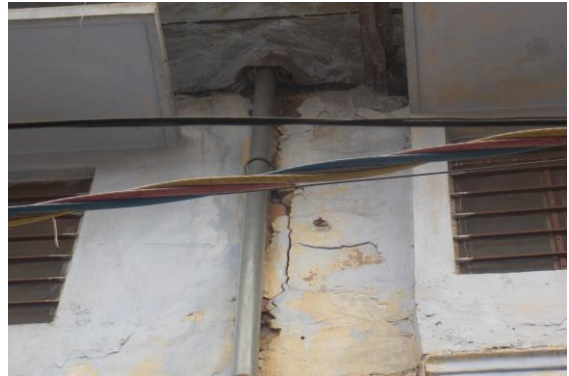
Photo 73

Peeling of Plaster on Front side Wall of House no.410 of Second Floor

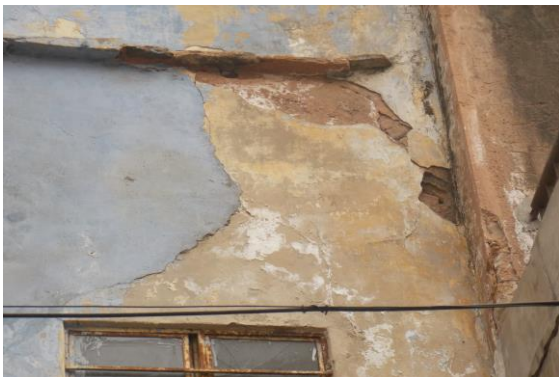
Photo 74

Peeling of Plaster on Front side Wall of House no.410 of First floor

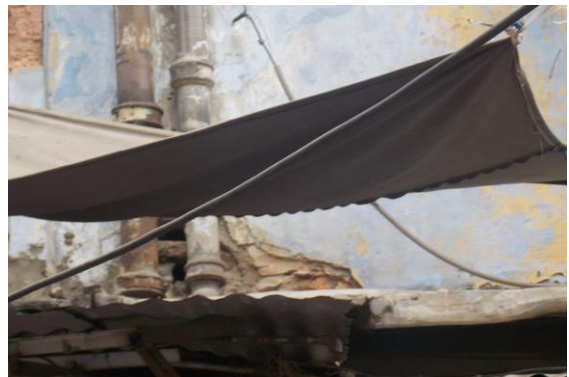
Photo 75

Peeling of Plaster on Front side Wall of House no.410 of First floor

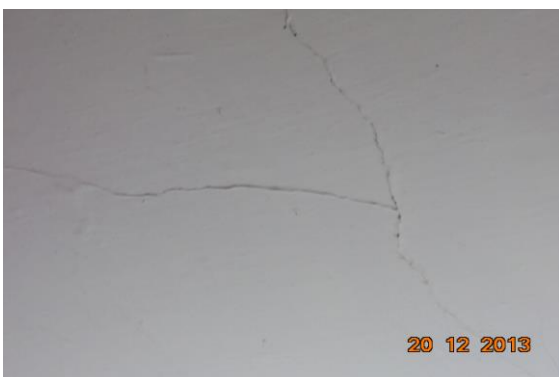
Photo 76

Peeling of Plaster on Roof of Shop No. 1 of Ground Floor

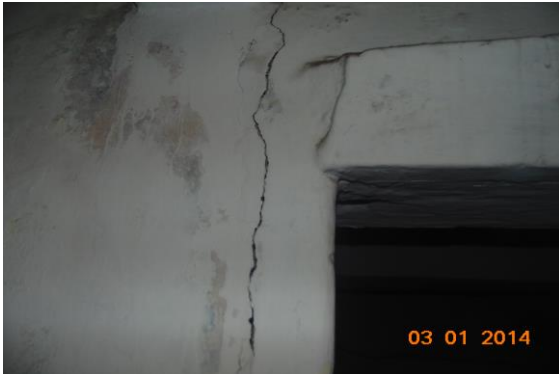
Photo 9
Inclined Crack on Wall No. 3 of Balcony 3, Second Floor - Part A
Approx. Width = 3mm, Approx. Length = 1.3m.
Distance from w2 = 1.5m, Height from Floor = 1.05m.

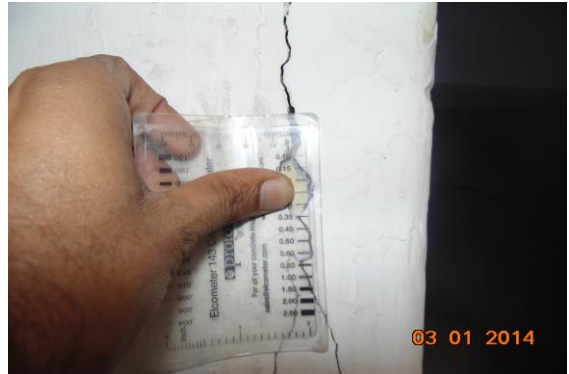
Photo 9A
Inclined Crack on Wall No. 3 of Balcony 3, Second Floor - Part A
Approx. Width = 3mm, Approx. Length = 1.3m.
Distance from w2 = 1.5m, Height from Floor = 1.05m.

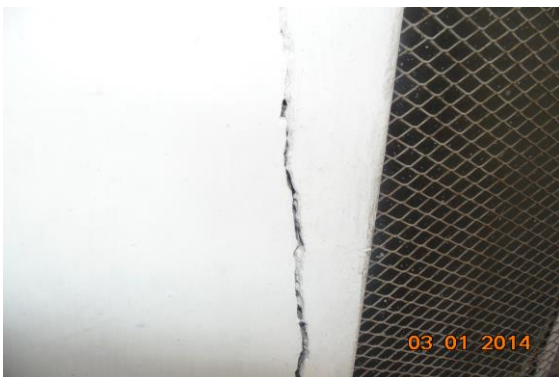
Photo 10
Vertical Crack on Wall No. 3 of Balcony 5, Second Floor - Part A
Approx. Width = 2.5mm, Approx. Length = 0.6m.
Distance from w1 = 3.5m, Height from Floor = 0.5m.

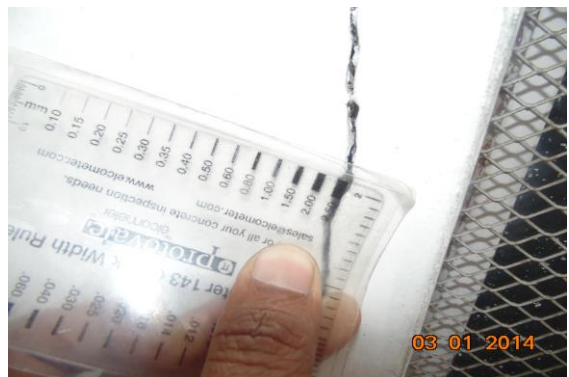
Photo 10A
Vertical Crack on Wall No. 3 of Balcony 5, Second Floor - Part A
Approx. Width = 2.5mm, Approx. Length = 0.6m.
Distance from w1 = 3.5m, Height from Floor = 0.5m.

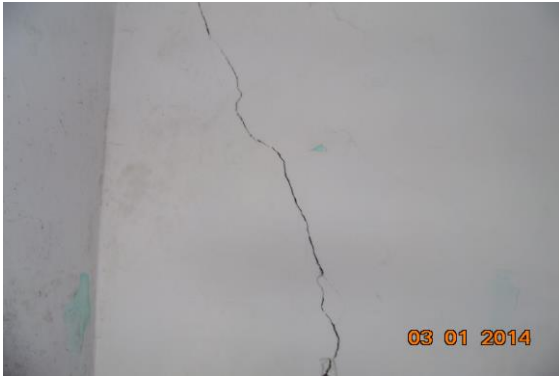
Photo 11

Inclined Crack on Wall No. 2 of Stair SF to TF, Second Floor - Part A
Approx. Width = 2.5mm, Approx. Length = 1m.
Distance from w4 = 0.35m, Height from Floor = 1.5m.

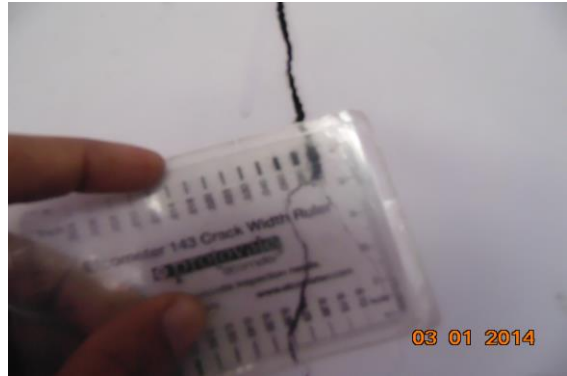
Photo 11A

Inclined Crack on Wall No. 2 of Stair SF to TF, Second Floor - Part A
Approx. Width = 2.5mm, Approx. Length = 1m. Distance from w4 = 0.35m, Height from Floor = 1.5m.

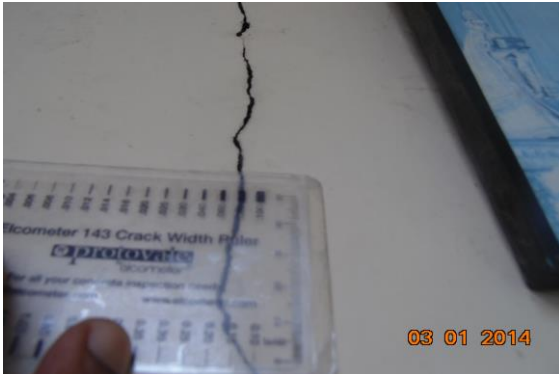
Photo 12

Inclined Crack on Wall No. 3 of Balcony 5, Second Floor - Part A
Approx. Width = 1.5mm, Approx. Length = 1.5m.
Distance from w1 = 1m, Height from Floor = 1.5m.

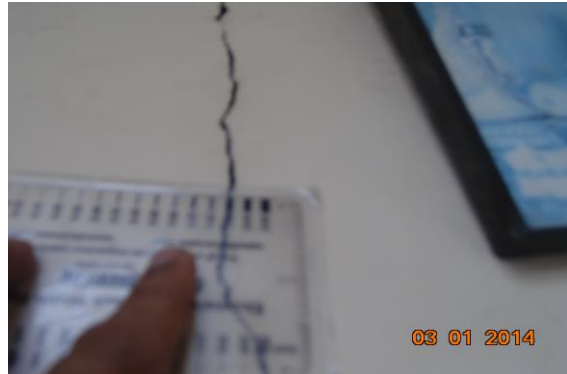
Photo 12A

Inclined Crack on Wall No. 3 of Balcony 5, Second Floor - Part A
Approx. Width = 1.5mm, Approx. Length = 1.5m.
Distance from w1 = 1m, Height from Floor = 1.5m.

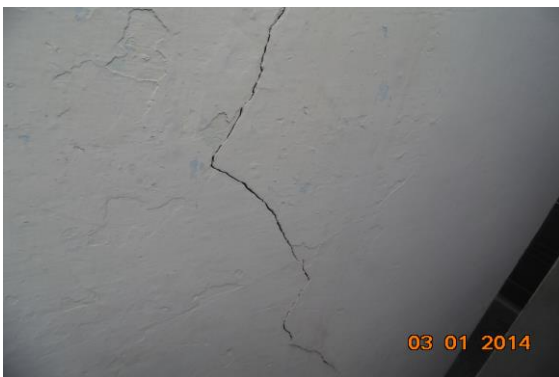
Photo 13

Inclined Crack on Parapet Wall of Balcony 1, Third Floor - Part A
Approx. Width = 1.5mm, Approx. Length = 1.1m. Distance from w3 = 0.5m, Height from Floor = 0.6m.

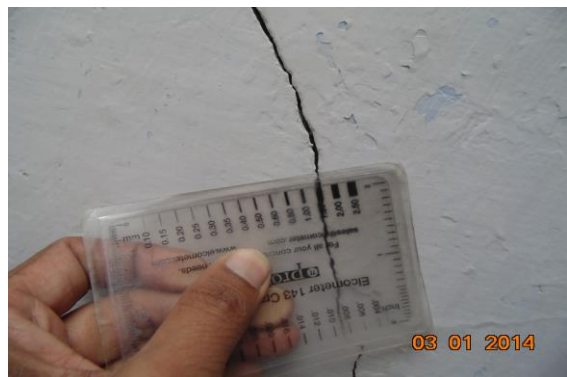
Photo 13A

Inclined Crack on Parapet Wall of Balcony 1, Third Floor - Part A
Approx. Width = 1.5mm, Approx. Length = 1.1m. Distance from w3 = 0.5m, Height from Floor = 0.6m.

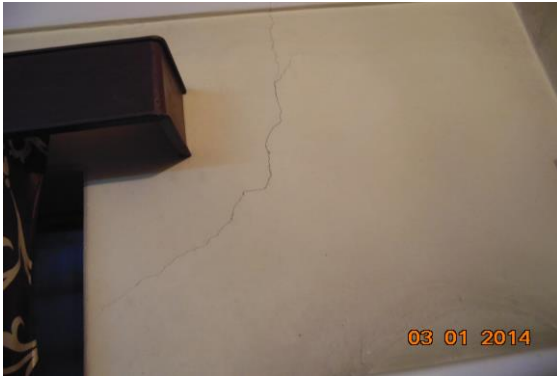
Photo 14

Inclined Crack on Roof of Room No. 1, Second Floor - Part B
Approx. Width = 0.5mm, Approx. Length = 0.7m.
Distance from W1 = 0.7m, Height from Floor = 1.7m.

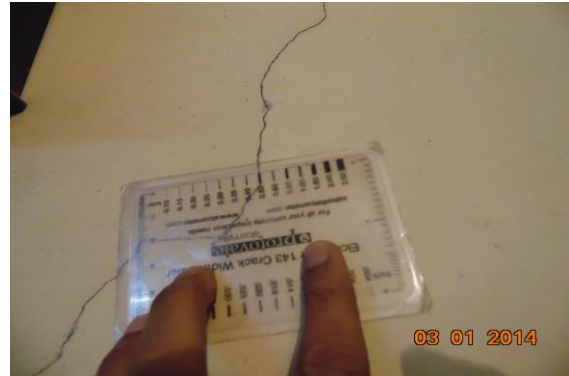
Photo 14A

Inclined Crack on Roof of Room No. 1, Second Floor - Part B
Approx. Width = 0.5mm, Approx. Length = 0.7m.
Distance from W1 = 0.7m, Height from Floor = 1.7m.

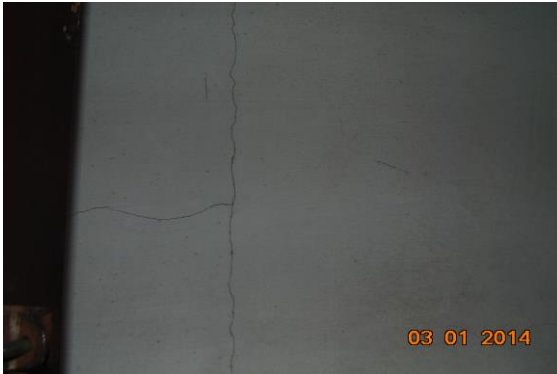
Photo 15

Vertical Crack on Wall No. 4 of Bathroom No. , Second Floor - Part B
Approx. Width = 0.35mm, Approx. Length = 1.7m. Distance from w1 = 0.6m, Height from Floor = 1m.

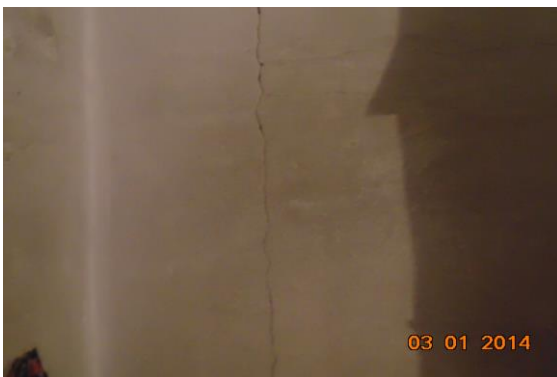
Photo 16

Vertical Crack on Wall No. 1 of Passage, Second Floor - Part B
Approx. Width = 0.35mm, Approx. Length = 1.1m.
Distance from w3 = 0.2m, Height from Floor = 1m.

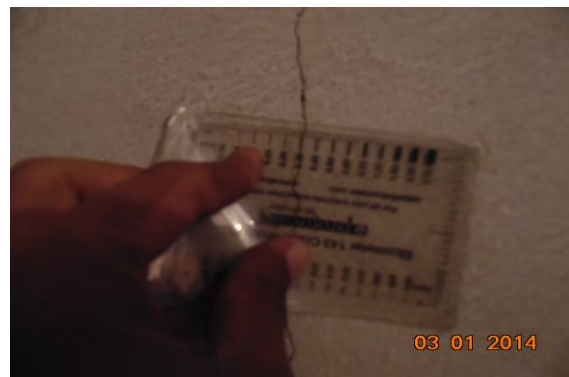
Photo 16A

Vertical Crack on Wall No. 1 of Passage, Second Floor - Part B
Approx. Width = 0.35mm, Approx. Length = 1.1m.
Distance from w3 = 0.2m, Height from Floor = 1m.

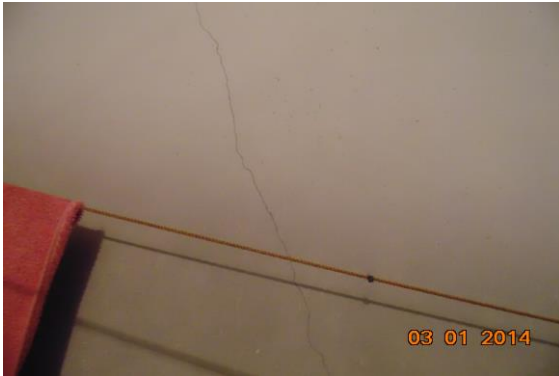
Photo 17

Inclined Crack on Second Floor - Part B
Approx. Width = 0.6mm, Approx. Length = 1.1m.
Distance from w1 = 2m, Height from Floor = 1.4m.

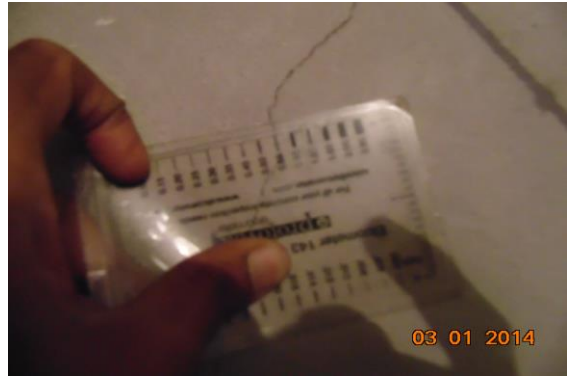
Photo 17A

Inclined Crack on of , Second Floor - Part B
Approx. Width = 0.6mm, Approx. Length = 1.1m.
Distance from w1 = 2m, Height from Floor = 1.4m.
