Pre Building Condition Survey Report

Name and Address of Structure :	Choti Chopar to Badi Chopar (Down Line)
---------------------------------	---

Name of the Project	Contract JMRC-UG1B “Design and Construction of Tunnel between Chandpole and Badi Chouper and reverse line by Shield TBM, Underground Metro Stations at Choti Chouper and Badi Chouper by Cut and Cover Methods on East West Corridor of Jaipur Metro Rail Corporation Limited .”	
Owner :

Pre Building Condition Survey Report Choti Chopar to Badi Chopar (Down Line)

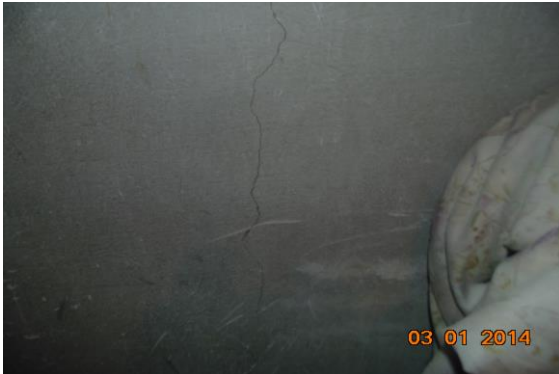
Photo 18

Inclined Crack on Second Floor - Part B
Approx. Width = 0.35mm, Approx. Length = 1.2m.
Distance from w1 = 1.5m, Height from Floor = 0m.

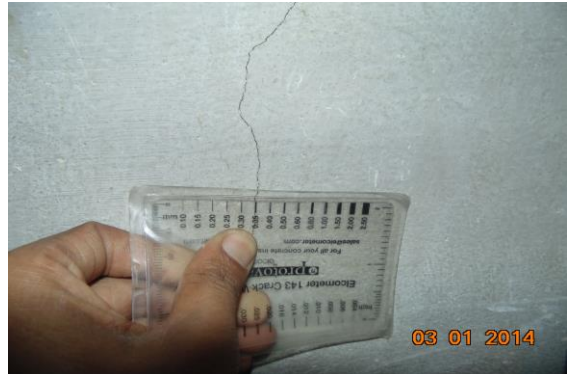
Photo 18A

Inclined Crack on Second Floor - Part B
Approx. Width = 0.35mm, Approx. Length = 1.2m.
Distance from w1 = 1.5m, Height from Floor = 0m.

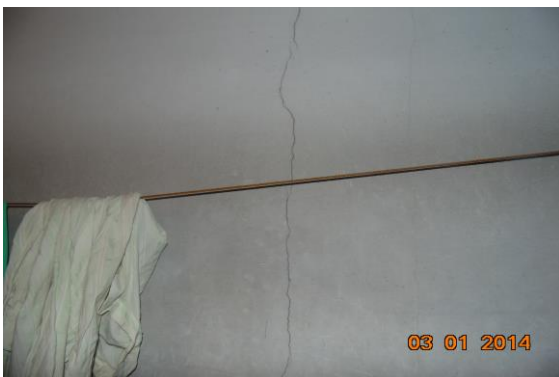
Photo 19

Vertical Crack on Wall No. 4 of Store, Second Floor - Part B
Approx. Width = 0.6mm, Approx. Length = 1.3m.
Distance from w1 = 3m, Height from Floor = 1m.

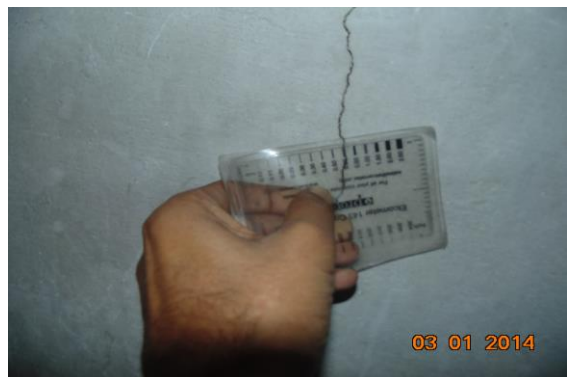
Photo 19A

Vertical Crack on Wall No. 4 of Store, Second Floor - Part B
Approx. Width = 0.6mm, Approx. Length = 1.3m.
Distance from w1 = 3m, Height from Floor = 1m.

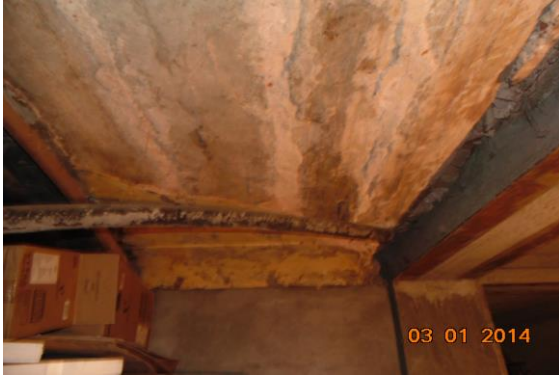
Photo 20

Peeling of Plaster on Roof of Room No. 1 of Ground Floor - Part A

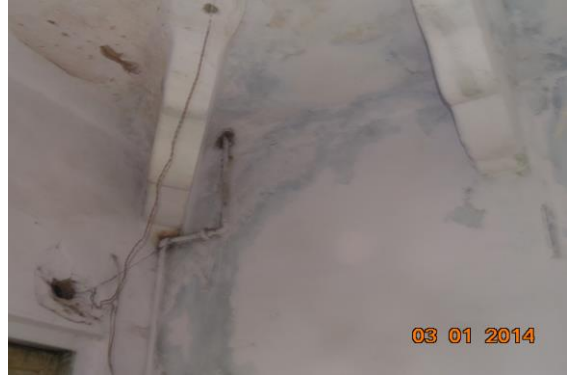
Photo 21

Dampness/Seepage on Wall No. 2 & 4 of Courtyard of Ground Floor - Part A

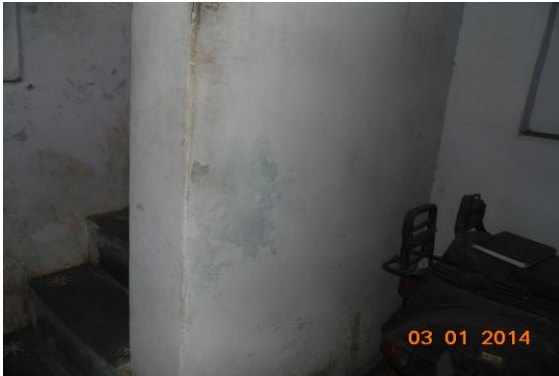
Photo 22

Peeling of Plaster on Wall No. 2 of Courtyard of Ground Floor - Part A

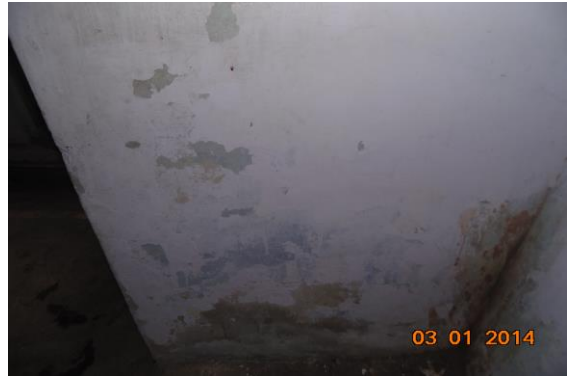
Photo 23

Peeling of Plaster on Wall No. 1 of Stair GF to FF of Ground Floor - Part A

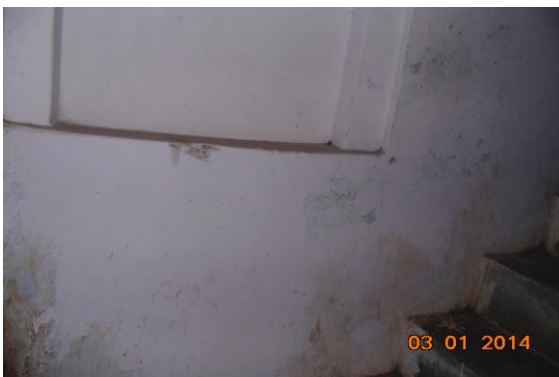
Photo 24

Peeling of Plaster on Wall No. 4 of Stair GF to FF of Ground Floor - Part A

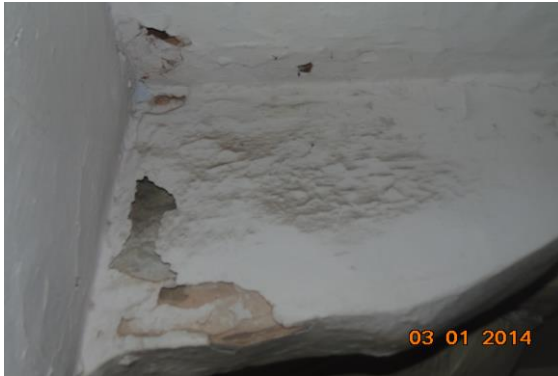
Photo 26

Peeling of Plaster on Wall No. 3 of Balcony 1 of First Floor - Part A

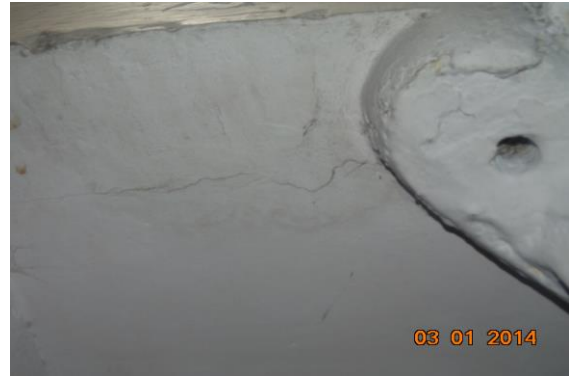
Photo 27

Plaster Crack on Wall No. 1 of Balcony 1 of First Floor - Part A

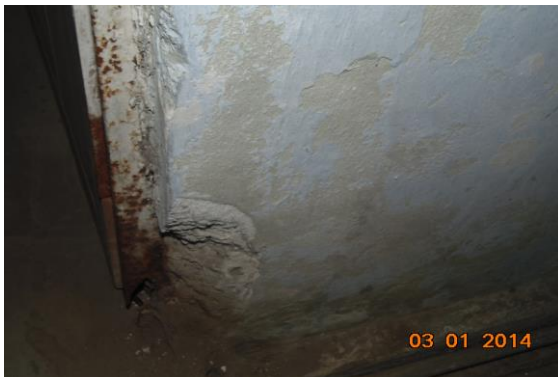
Photo 28

Plaster Crack on Wall No. 1 of Balcony 1 of First Floor - Part A

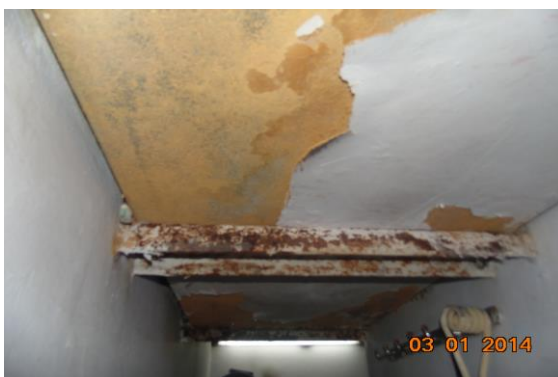
Photo 30

Peeling of Plaster on Roof of Passage of First Floor - Part A

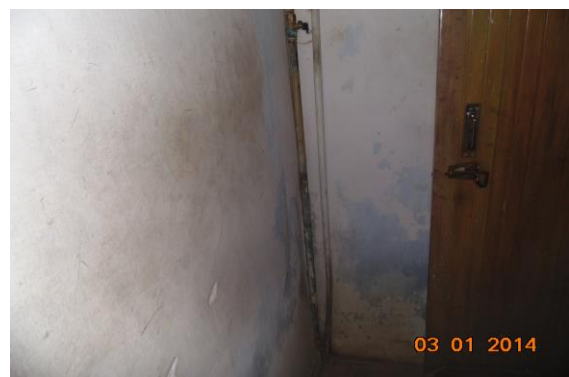
Photo 31

Peeling of Plaster on Wall No. 2 & 4 of Passage of First Floor - Part A

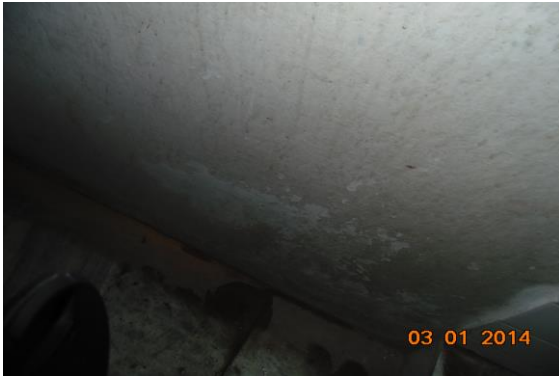
Photo 32

Dampness/Seepage on Wall No. 3 of Passage of First Floor - Part A

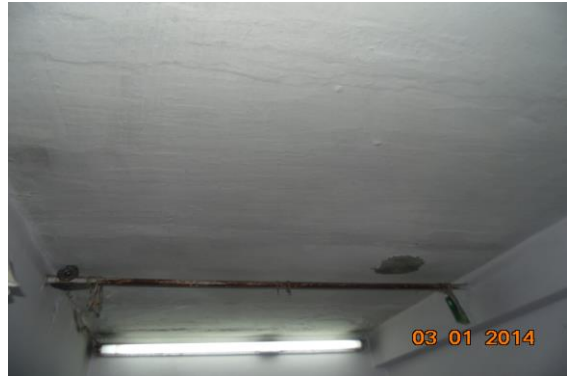
Photo 33

Dampness/Seepage on Roof of Toilet No. 1 of First Floor - Part A

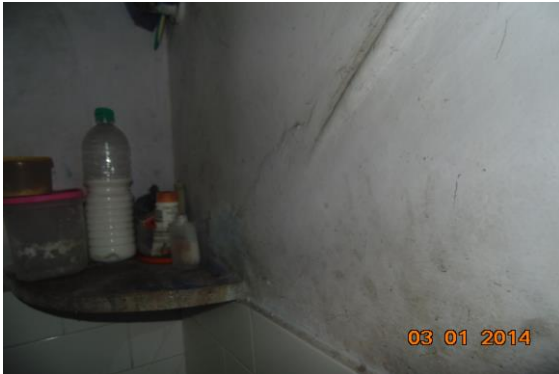
Photo 34

Dampness/Seepage on Wall No. 3 of Toilet No. 1 of First Floor - Part A

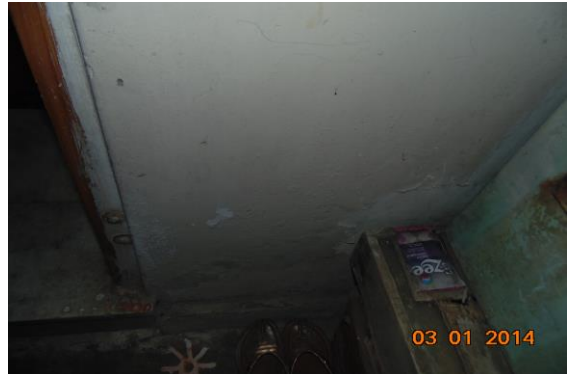
Photo 35

Dampness/Seepage on Wall No. 4 of Balcony 2 of First Floor - Part A

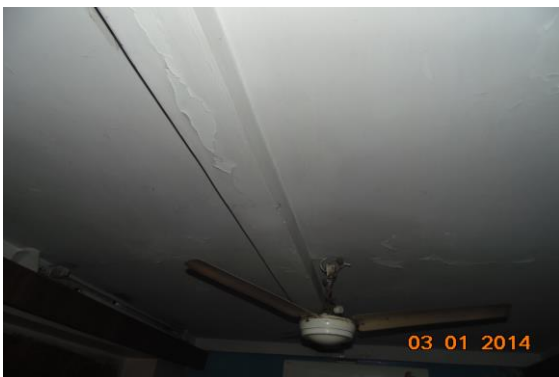
Photo 36

Peeling of Plaster on Roof of Room No. 1 of First Floor - Part A

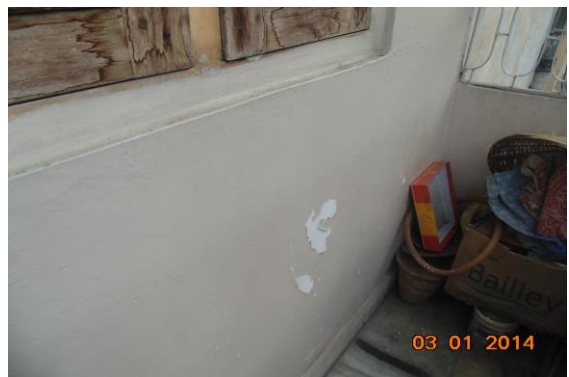
Photo 37

Peeling of Plaster on Wall No. 3 of Balcony 5 of First Floor - Part A

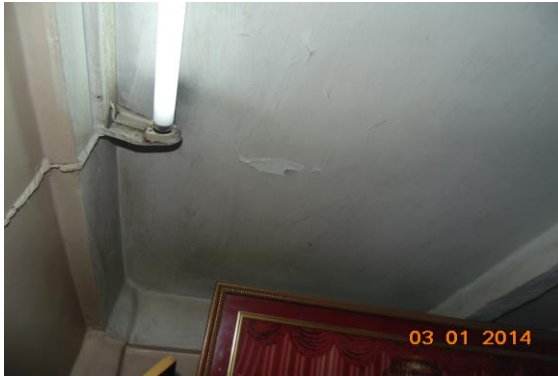
Photo 38

Peeling of Plaster on Roof of Dressing Room of First Floor - Part A

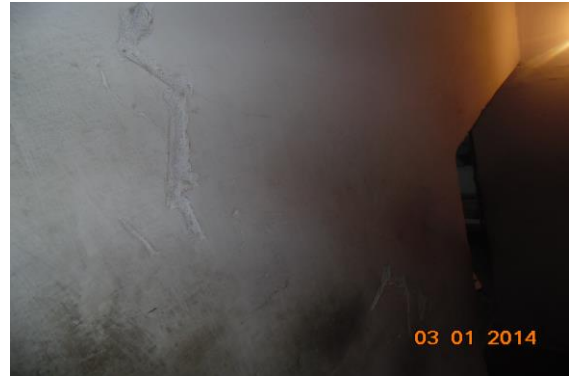
Photo 39

Peeling of Plaster on Wall No. 1 of Stair FF to SF of First Floor - Part A

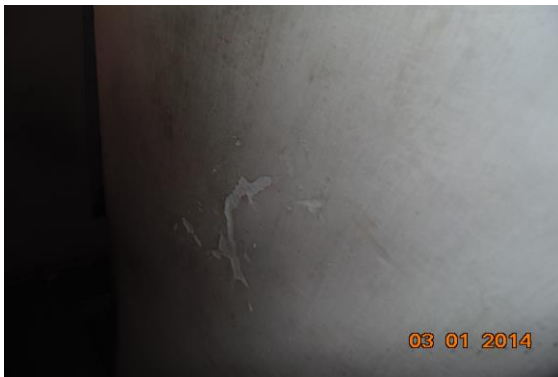
Photo 40

Peeling of Plaster on Wall No. 2 of First Floor - Part A

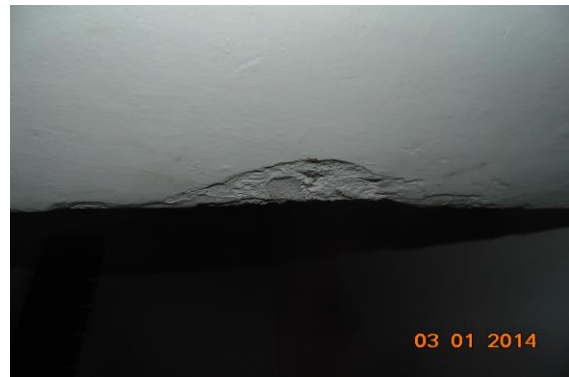
Photo 41

Peeling of Plaster on Roof of First Floor - Part A

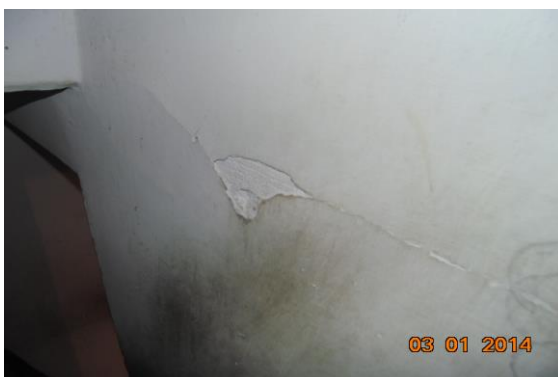
Photo 42

Peeling of Plaster on Wall No. 1 of First Floor - Part A

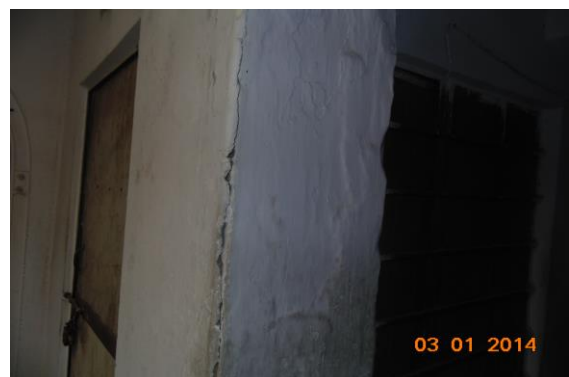
Photo 43

Plaster Crack on Wall No. 3 of Balcony 3 of Second Floor - Part A

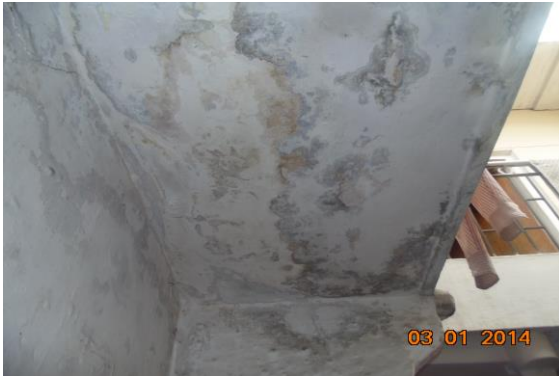
Photo 44

Dampness/Seepage on Balcony 3 Shed of Second Floor - Part A

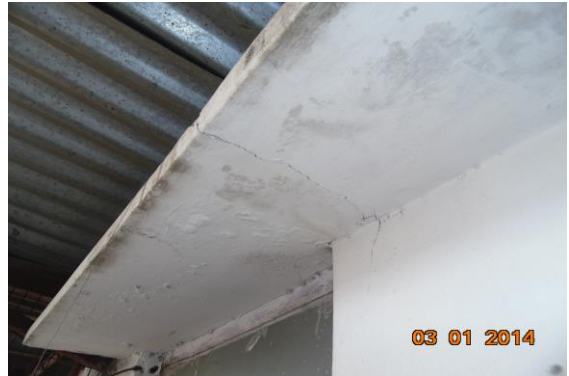
Photo 45

Plaster Crack on Balcony 5 Shed of Second Floor - Part A

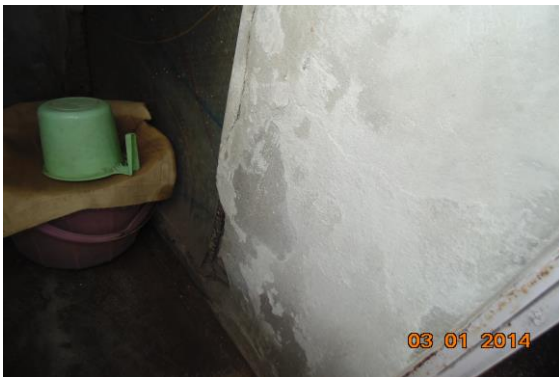
Photo 46

Dampness/Seepage on Wall No. 3 of Balcony 5 of Second Floor - Part A

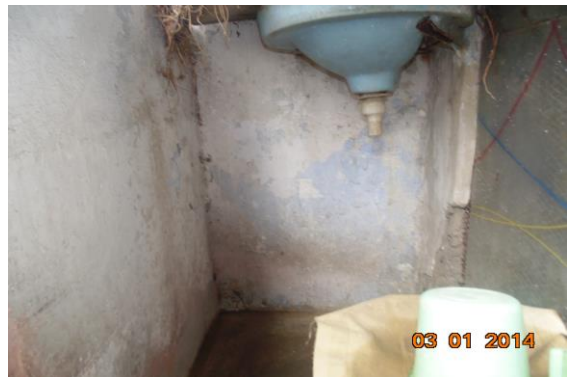
Photo 47

Peeling of Plaster on Wall No. 2, 3 & 4 of Balcony 5 of Second Floor - Part A

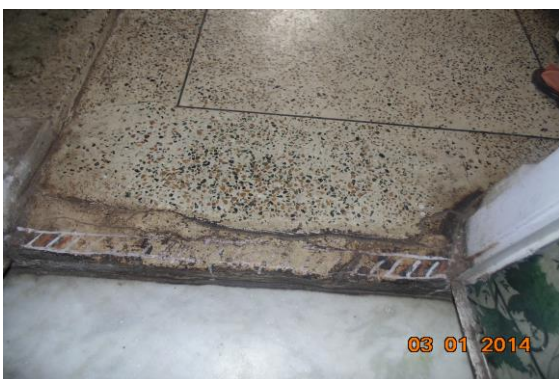
Photo 48

40	Floor Kitchen Second Floor - Part A	Damaged Portion	48

Damaged Portion on Floor of Kitchen of Second Floor - Part A

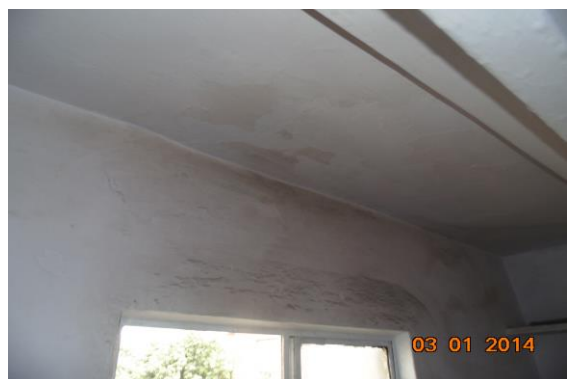
Photo 49

Dampness/Seepage on Wall No.2 & Roof of Kitchen of Second Floor - Part A

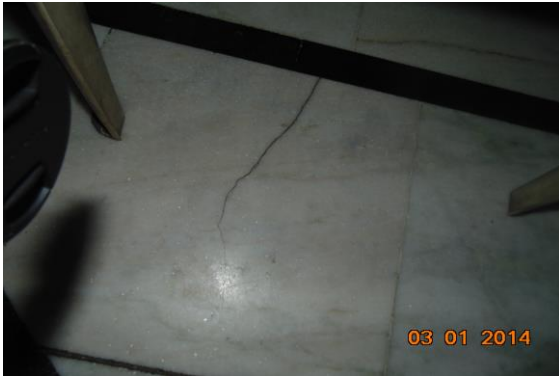
Photo 50

Peeling of Plaster on Floor of Room No. 3 of Second Floor - Part A

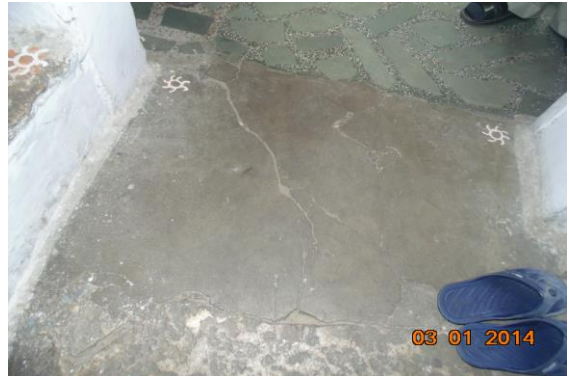
Photo 51

Plaster Crack on Floor of Stair Passage of Second Floor - Part A

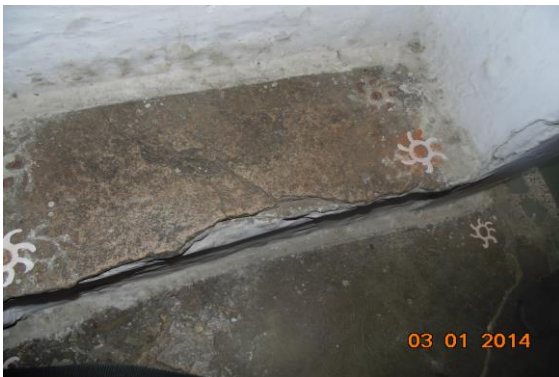
Photo 52

Peeling of Plaster on Stair Step SF to TF of Second Floor - Part A

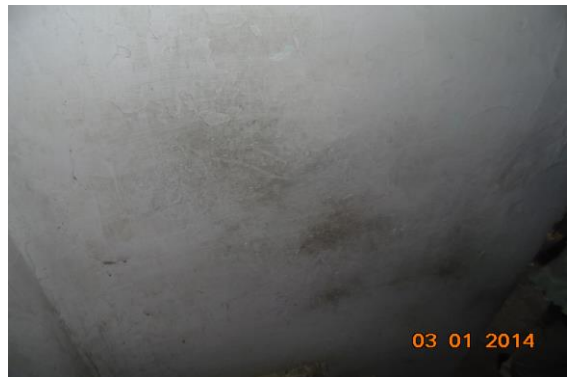
Photo 53

Dampness/Seepage on Wall No. 2 of Stair SF to TF of Second Floor - Part A

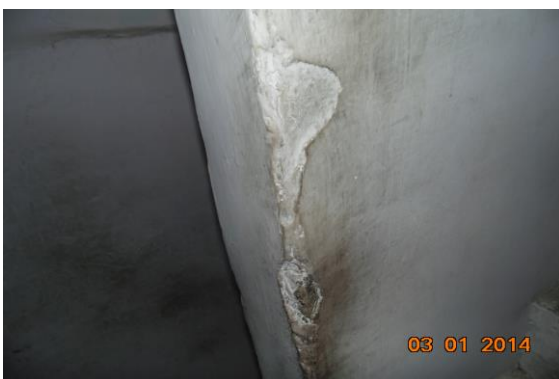
Photo 54

Peeling of Plaster on Wall No. 1 of Stair SF to TF of Second Floor - Part A

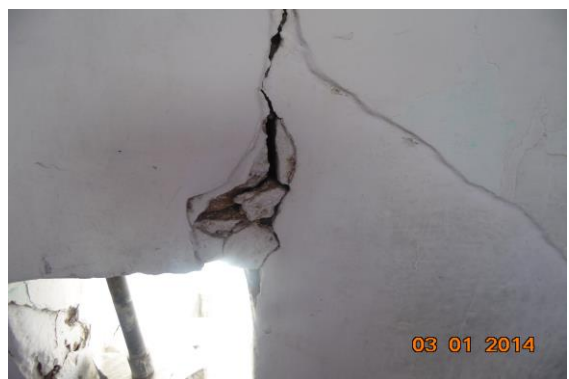
Photo 55

Peeling of Plaster on Wall No. 2 of Stair SF to TF of Second Floor - Part A

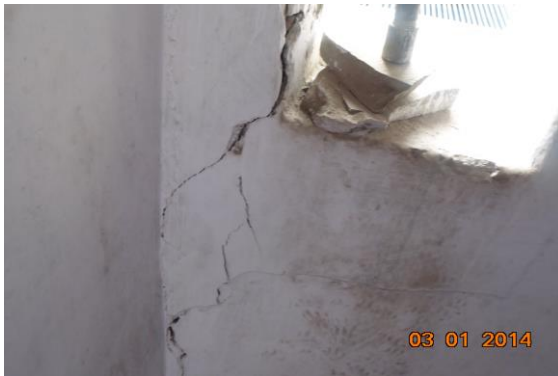
Photo 56

Peeling of Plaster on Wall No. 2 of Stair SF to TF of Second Floor - Part A

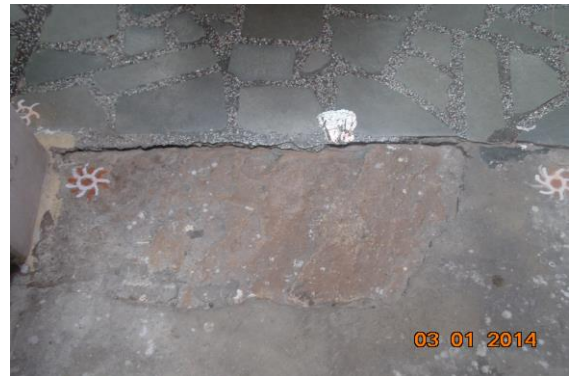
Photo 57

Peeling of Plaster on Floor of Passage of Second Floor - Part A

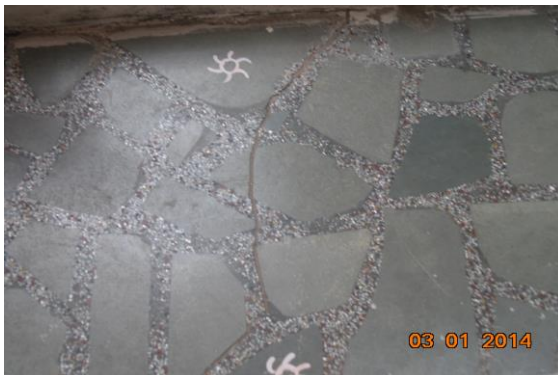
Photo 58

Plaster Crack on Floor of Balcony 1 of Second Floor - Part A

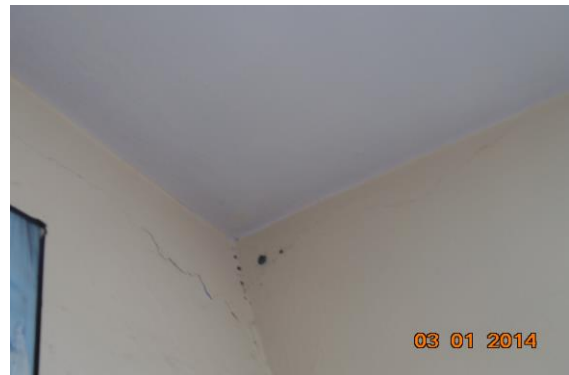
Photo 59

Plaster Crack on Wall No. 1 & 3 of Balcony 1 of Third Floor - Part A

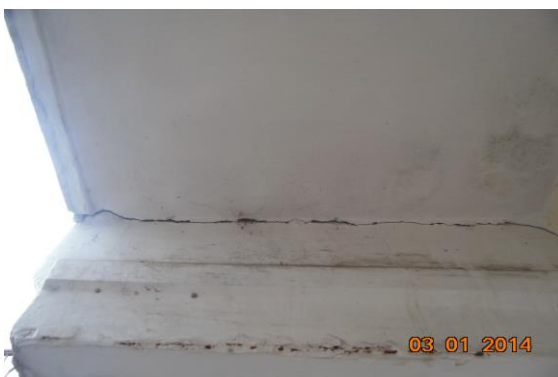
Photo 60

Plaster Crack on Balcony 1 Shed of Third Floor - Part A

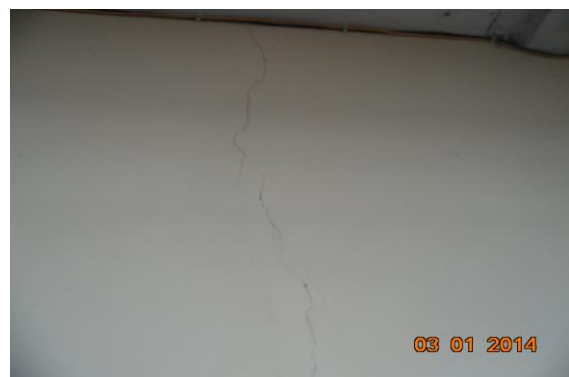
Photo 61

Plaster Crack on Wall No. 1 of Balcony 1 of Third Floor - Part A

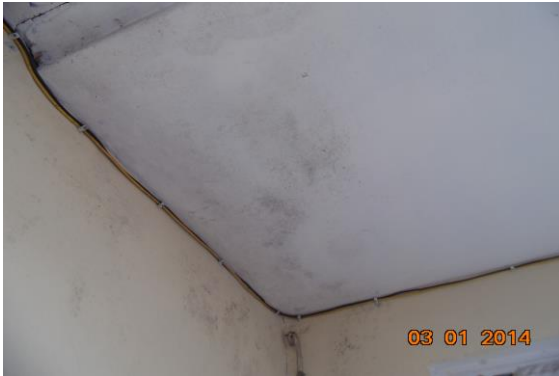
Photo 62

Dampness/Seepage on Roof of Balcony 1 Shed of Third Floor - Part A

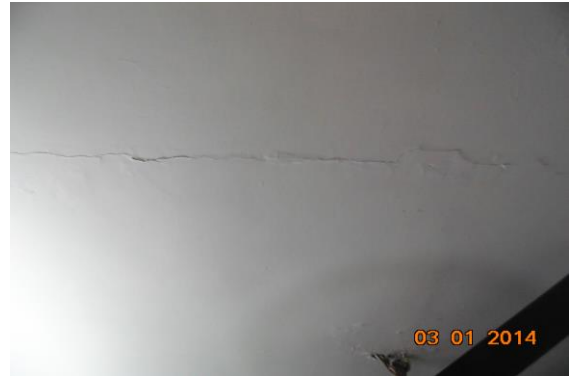
Photo 63

Plaster Crack on Roof of Room No. 1 of Third Floor - Part A

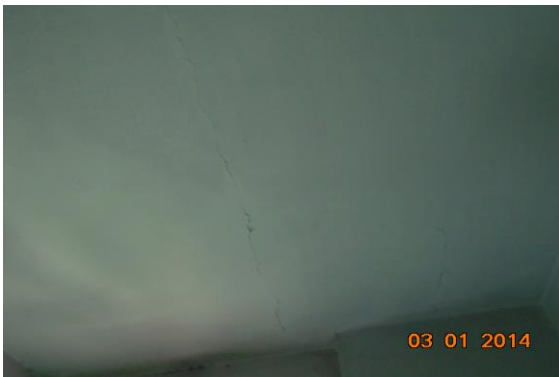
Photo 64

Plaster Crack on Roof of Toilet No. 1 of Third Floor - Part A

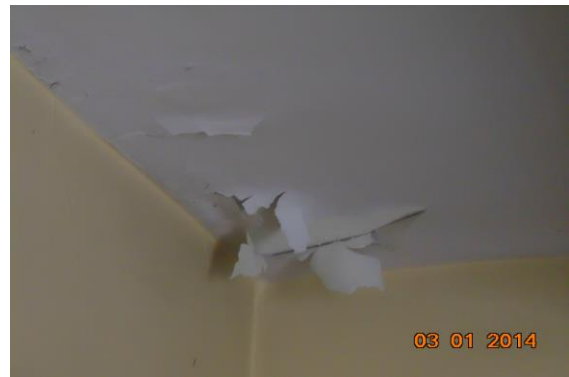
Photo 65

Peeling of Plaster on Roof of Room No. 3 of Third Floor - Part A

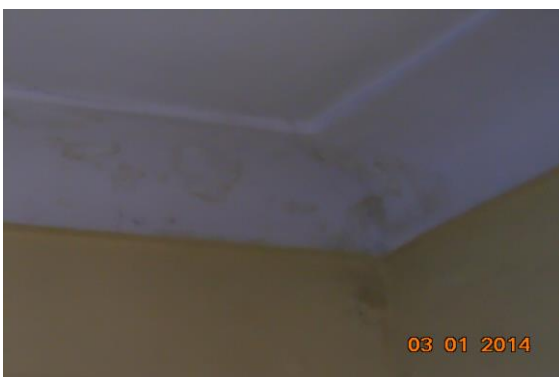
Photo 66

Dampness/Seepage on Wall No. 2 & Roof of Room No. 3 of Third Floor - Part A

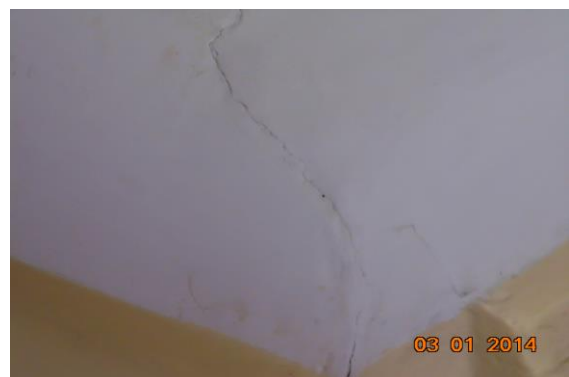
Photo 67

Plaster Crack on Roof of Room No. 3 of Third Floor - Part A

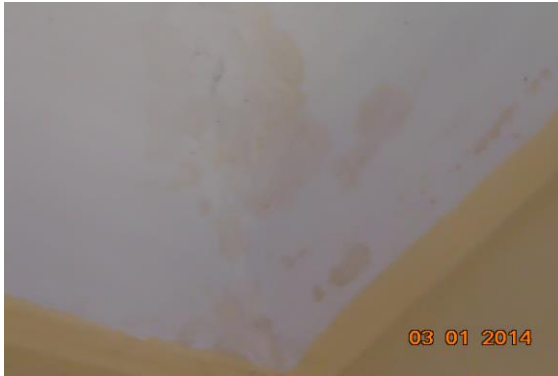
Photo 68
Dampness/Seepage on Roof of Room No. 3 of Third Floor - Part A

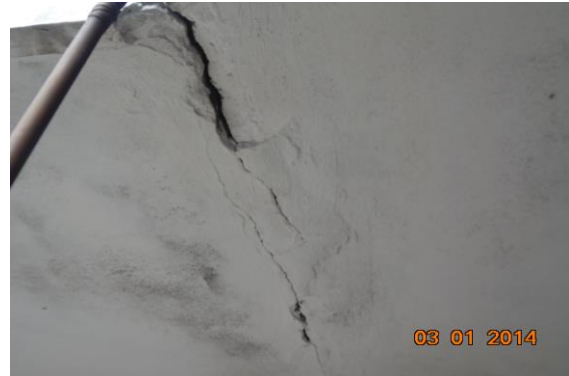
Photo 69
Peeling of Plaster on Balcony 4 Shed of Third Floor - Part A

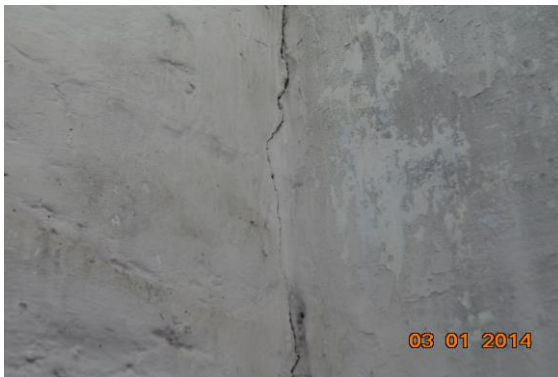
Photo 70
Plaster Crack on Wall No. 2 of Stair TF to Terrace of Third Floor - Part A

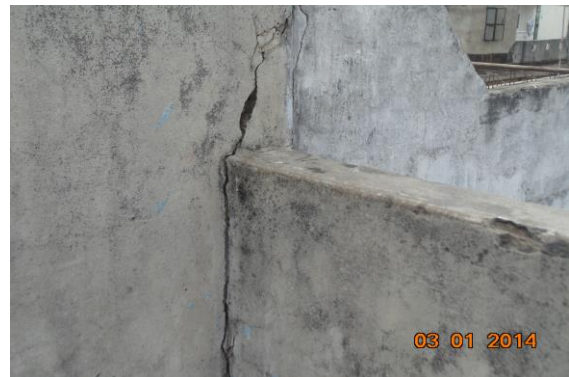
Photo 71
Plaster Crack on Third Floor - Part A

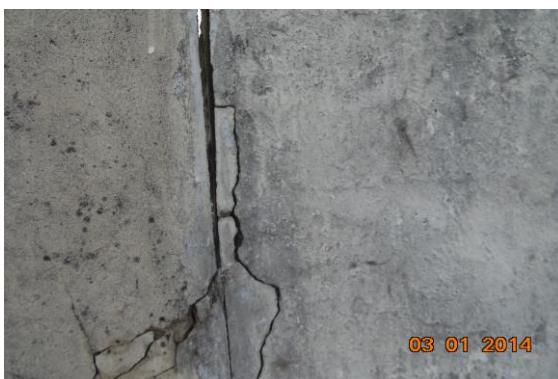
Photo 72
Damaged Portion on Wall No. 2 of Stair TF to Terrace of Third Floor - Part A

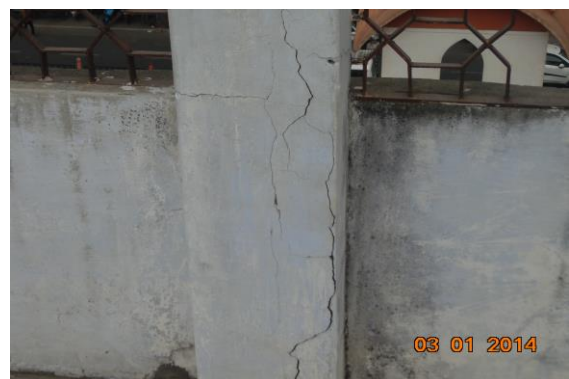
Photo 73
Plaster Crack on Wall No. 3 & 5 of Terrace

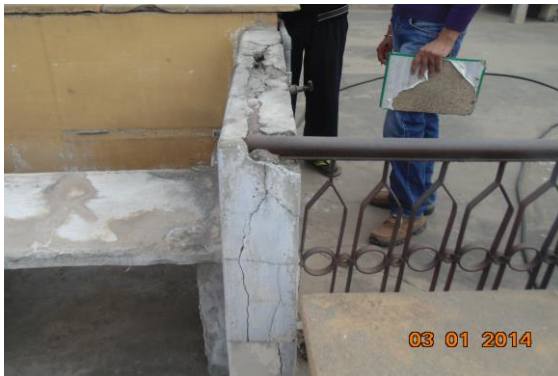
Photo 74
Peeling of Plaster on Tinshed Room of Terrace

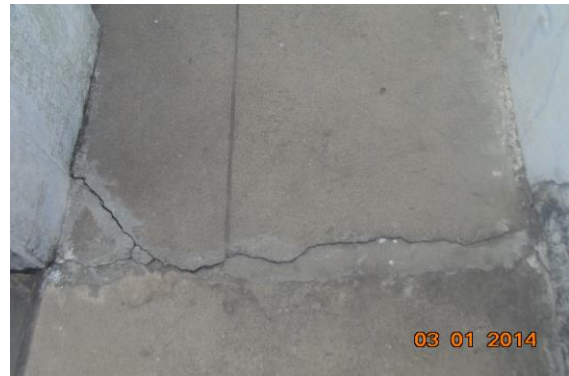
Photo 75
Plaster Crack on Parapet Wall No. 4 of Terrace

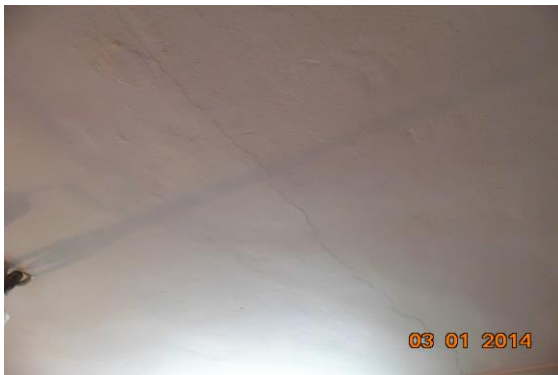
Photo 76
Plaster Crack on Parapet Wall No. 2 of Terrace

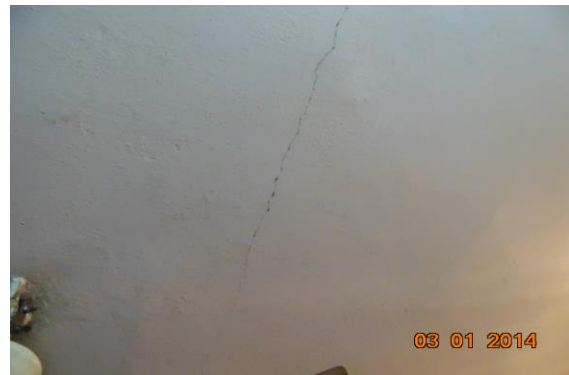
Photo 77
Plaster Crack on Floor of Terrace

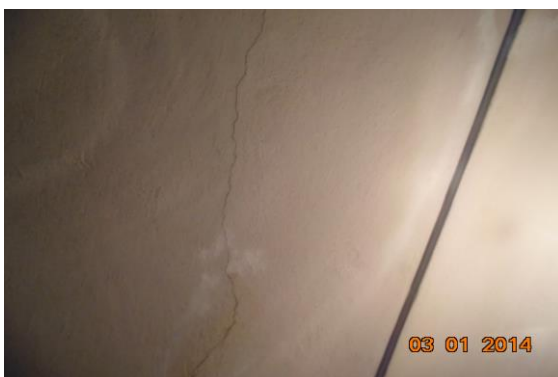
Photo 78
Plaster Crack on Roof of Room No. 1 of Second Floor - Part B

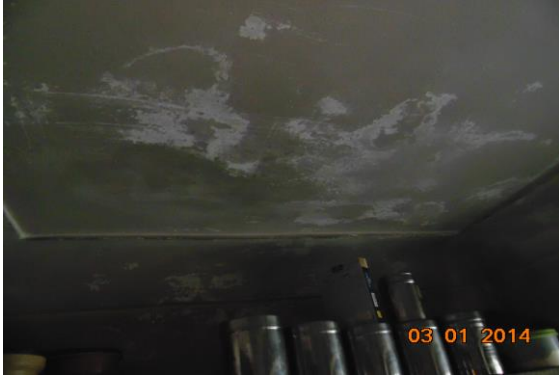
Photo 80
Peeling of Plaster on Second Floor - Part B

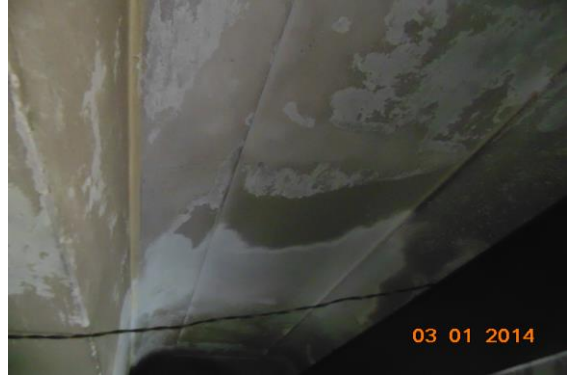
Photo 81
Peeling of Plaster on Wall No. 1 of Room No. 1 of Second Floor - Part B

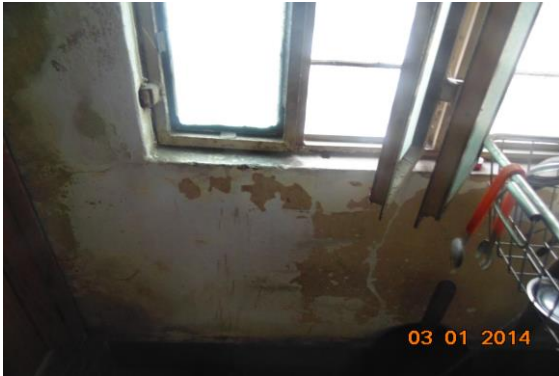
Photo 82
Peeling of Plaster on Roof of Kitchen of Second Floor - Part B

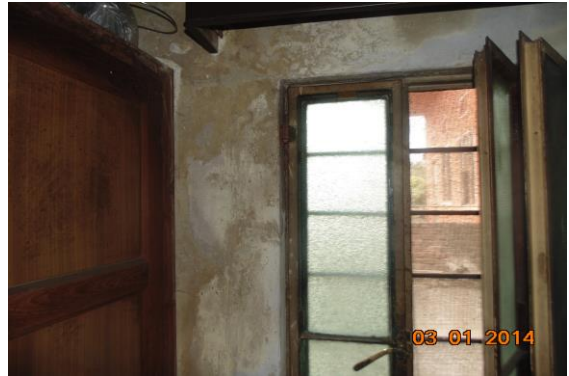
Photo 83
Peeling of Plaster on Roof of Kitchen of Second Floor - Part B

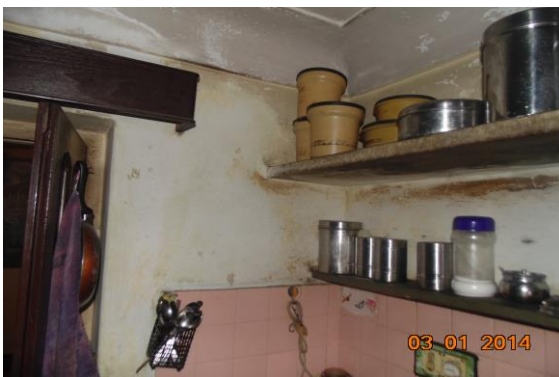
Photo 84
Dampness/Seepage on Wall No. 4 of Kitchen of Second Floor - Part B

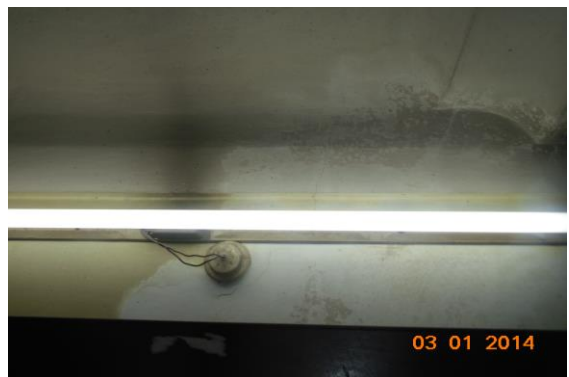
Photo 85
Dampness/Seepage on Wall No. 4 of Kitchen of Second Floor - Part B

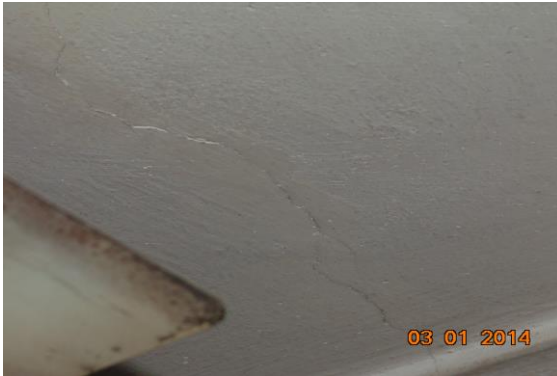
Photo 86

Plaster Crack on Wall No. 1 & 3 of Kitchen of Second Floor - Part B

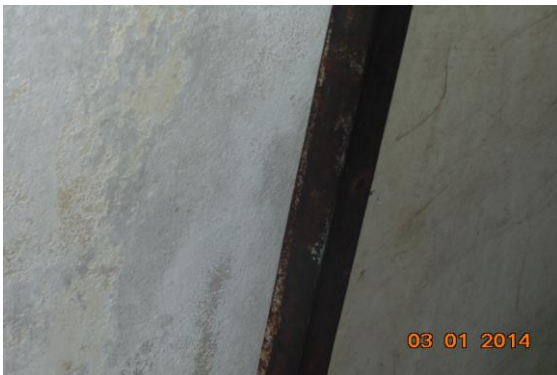
Photo 88

Dampness/Seepage on Roof of Room No. 2 of Second Floor - Part B

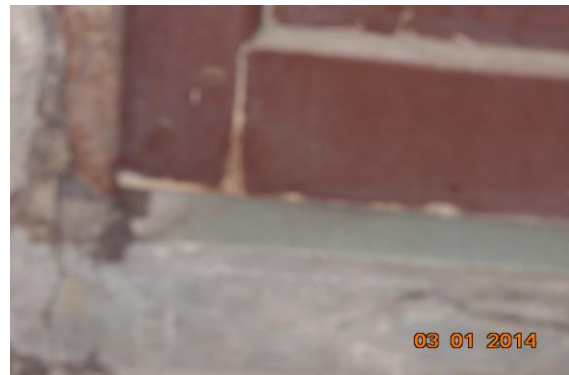
Photo 89

Peeling of Plaster on Wall No. 1, 4 & Roof, of Bathroom of Second Floor - Part B

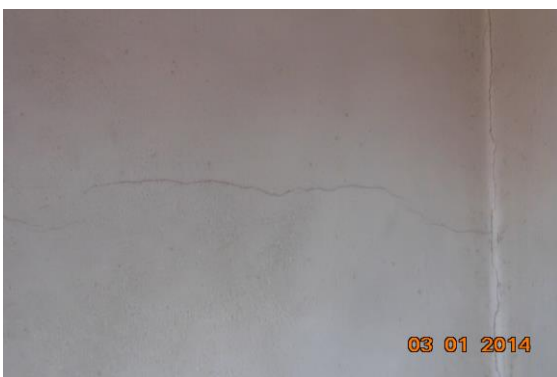
Photo 90

Plaster Crack on Wall No. 4 of Toilet No. 1 of Second Floor - Part B

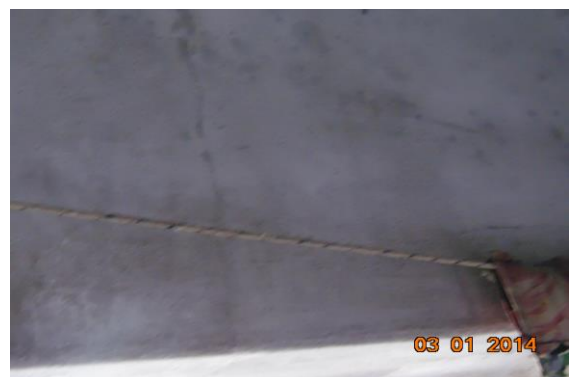
Photo 91

Dampness/Seepage on Second Floor - Part B

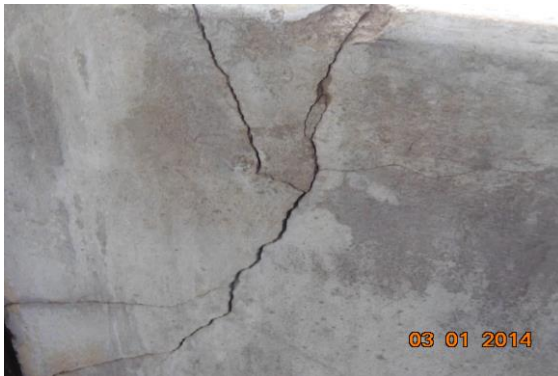
Photo 92

Peeling of Plaster on Wall No. 4 of Toilet No. 1 of Second Floor - Part B

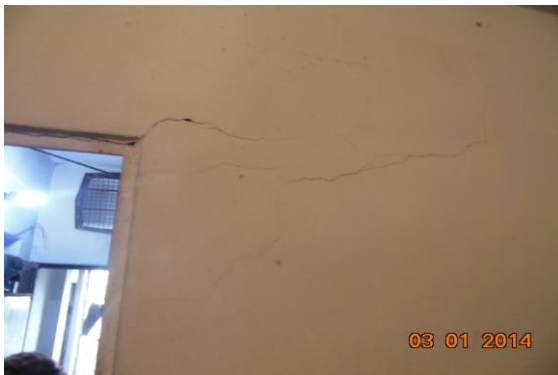
Photo 94

Plaster Crack on Wall No. 4 of Store of Second Floor - Part B

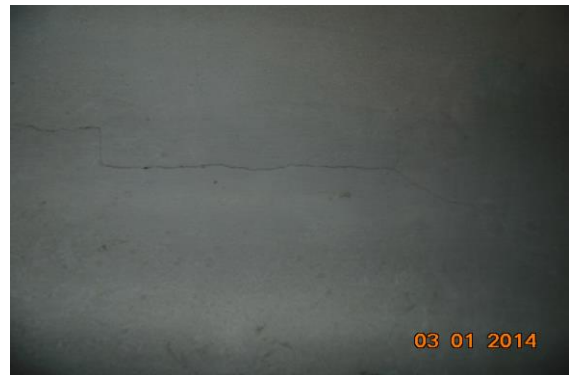
Photo 95

Plaster Crack on Wall No. 4 of Store of Second Floor - Part B

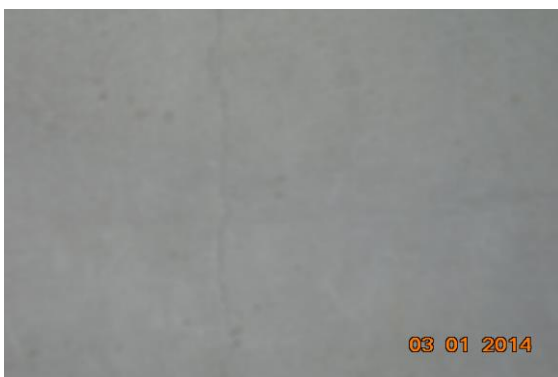
Photo 96

Plaster Crack on Wall No. 4 of Store of Second Floor - Part B

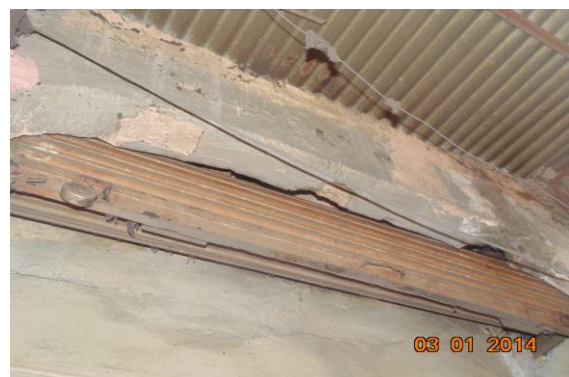
Photo 97

Peeling of Plaster on Side View of External façade

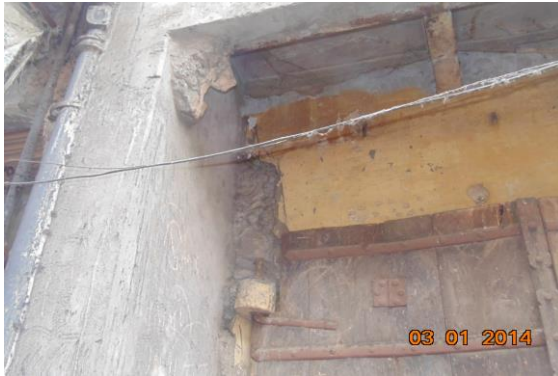
Photo 98
Peeling of Plaster on Shop 1 of External façade

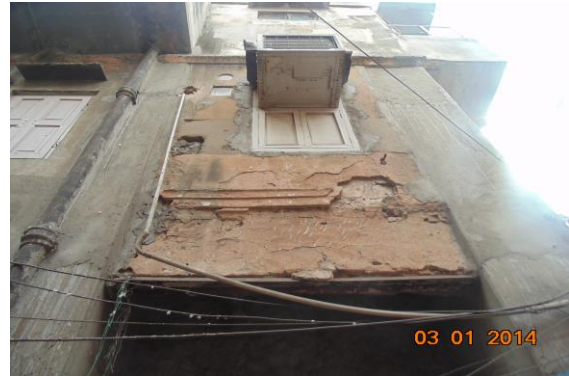
Photo 99
Peeling of Plaster on Entry Gate of Shop 3 of External façade

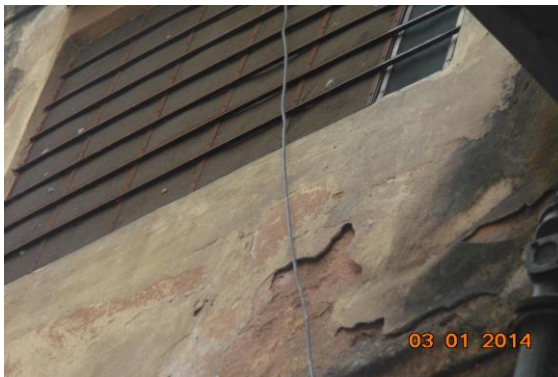
Photo 100
Peeling of Plaster on Shop 3 of External façade

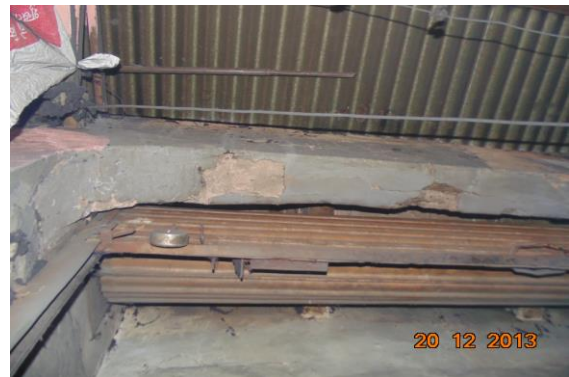
Photo 101
Peeling of Plaster on Roof of Shop of Ground Floor

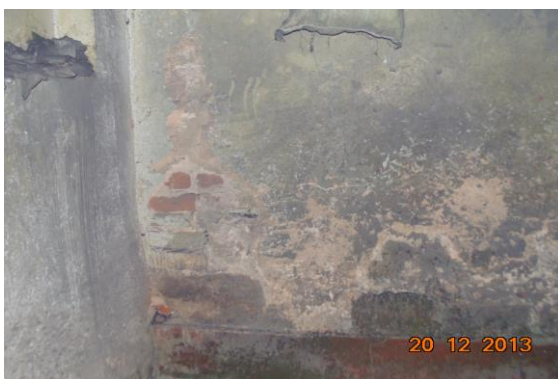
Photo 102
Peeling of Plaster on Shop No.2 of Ground floor

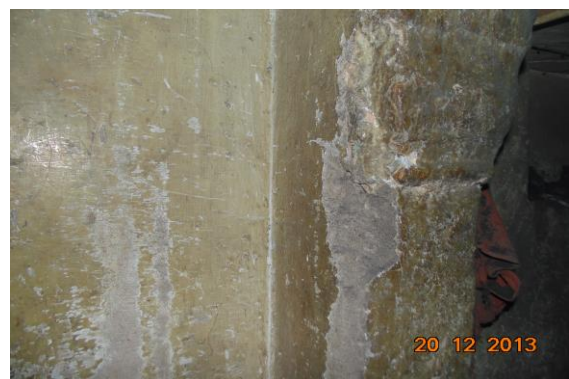
Photo 103
Peeling of Plaster on Roof of Shop No.2 of Ground floor

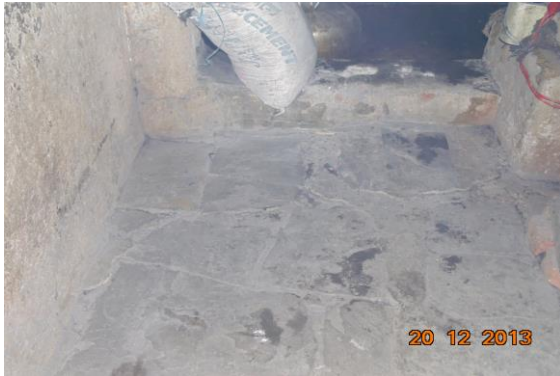
Photo 104
Damaged Portion on Wall No. 1 of Shop No.2 of Ground floor

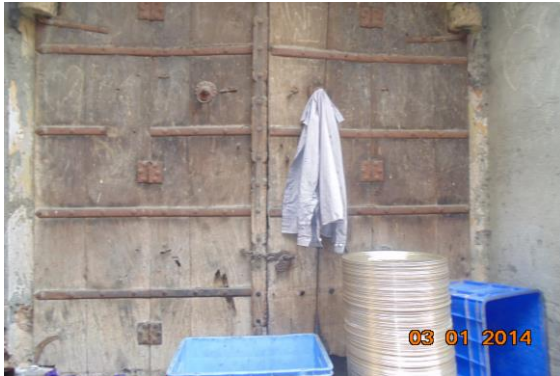
Photo 123
Shop on Third Floor - Part B Locked

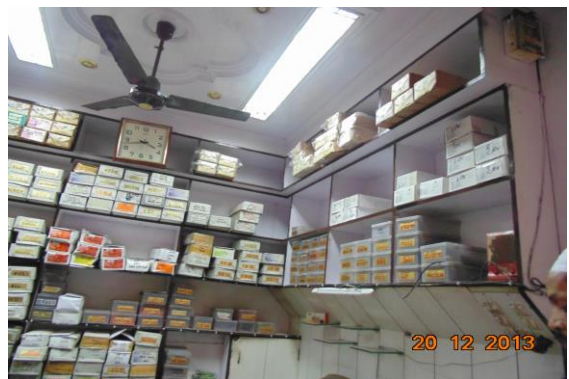
Photo 126
Shop of Ground Floor Covered With Material

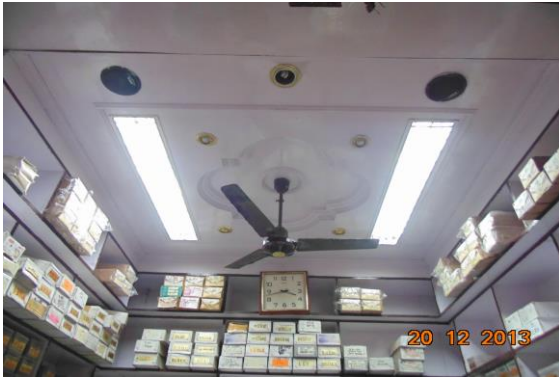
Photo 128

Wall No. 4 of Shop of Ground Floor Covered With Falls Ceiling

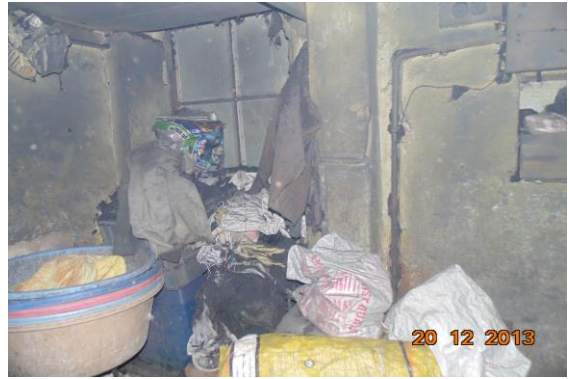
Photo 129

Wall No. 4 of Shop No.2 of Ground floor Covered With Material

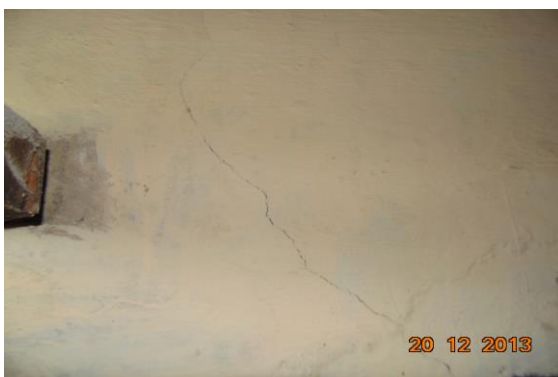
Summary of Cracks						
Defect ID	Location	Orientation	Appx. Width (mm)	Appx. Length (m)	Category	Photo No.
1	Outer Wall Toilet No. 1 Ground Floor	Inclined	0.5	0.5	Very Slight	5, 5A

Photo 5
Inclined Crack on Outer Wall of Toilet No. 1, Ground Floor
Approx. Width = 0.5mm, Approx. Length = 0.5m.
Distance from Wall No.4 = 1m, Height from Floor = 1.8m.

Photo 5A
Inclined Crack on Outer Wall of Toilet No. 1, Ground Floor
Approx. Width = 0.5mm, Approx. Length = 0.5m.
Distance from Wall No.4 = 1m, Height from Floor = 1.8m.

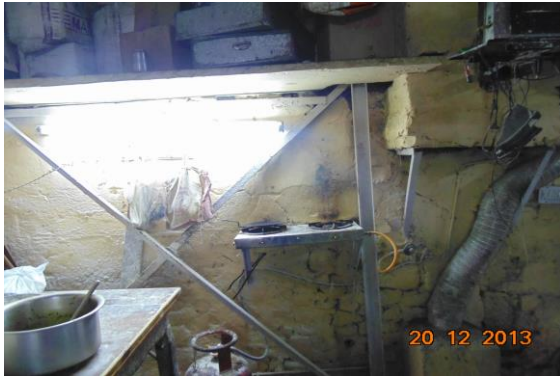
Photo 6
Peeling of Plaster on Wall No. 9 of Ground Floor

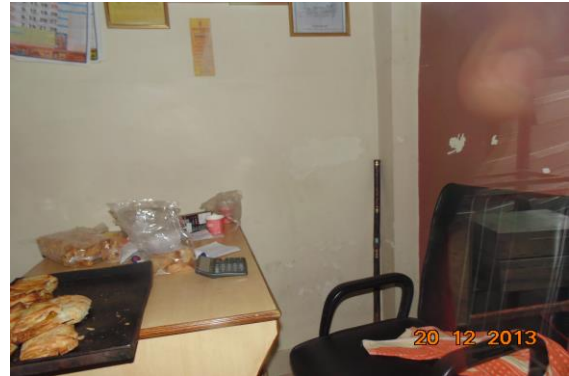
Photo 7
Peeling of Plaster on Wall No. 4 of Room No. 1 of Ground Floor

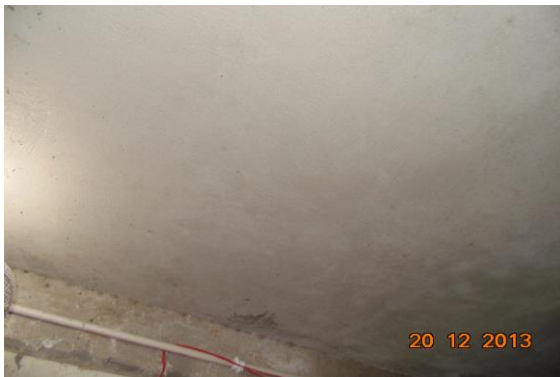
Photo 8
Peeling of Plaster on Roof of Ground Floor

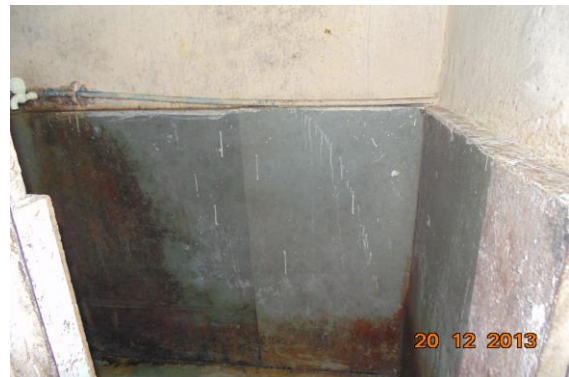
Photo 9
Bathroom No. of Ground Floor Covered With Tiles

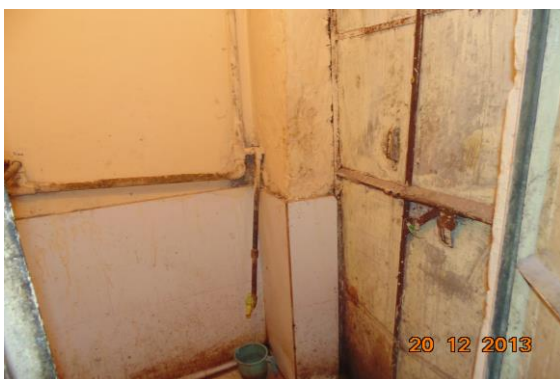
Photo 10
Toilet No. 1 of Ground Floor Covered With Tiles

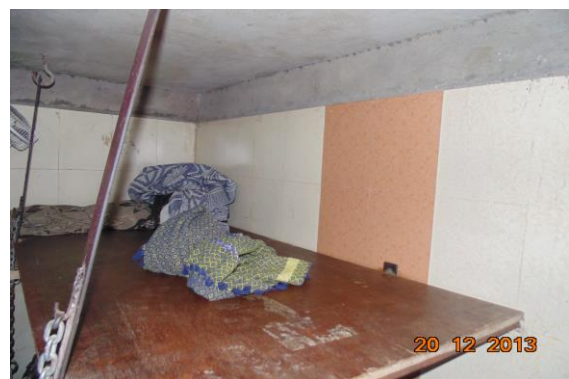
Photo 11
All walls of Ground Floor

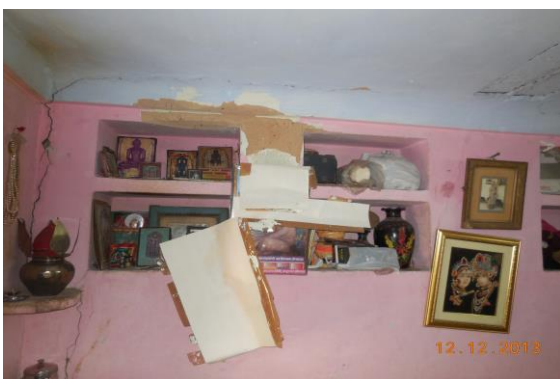
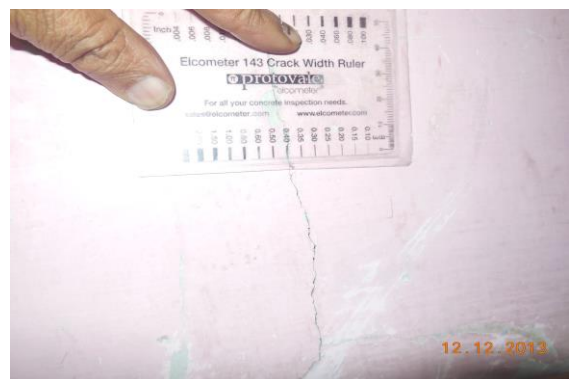
Photo 5
Inclined Crack on Roof of Room No. 1, House No. 424 Part A, Second Floor, Approx. Width = 0.45mm, Approx. Length = 2m. Distance from Wall No. 4 = 0.4m, Height from Floor = 0.5m.

Photo 5A
Inclined Crack on Roof of Room No. 1, House No. 424 Part A, Second Floor, Approx. Width = 0.45mm, Approx. Length = 2m. Distance from Wall No. 4 = 0.4m, Height from Floor = 0.5m.
