Pre Building Condition Survey Report

Name and Address of Structure :	Choti Chopar to Badi Chopar (Down Line)
---------------------------------	---

Name of the Project	Contract JMRC-UG1B “Design and Construction of Tunnel between Chandpole and Badi Chouper and reverse line by Shield TBM, Underground Metro Stations at Choti Chouper and Badi Chouper by Cut and Cover Methods on East West Corridor of Jaipur Metro Rail Corporation Limited .”	
Owner :

Pre Building Condition Survey Report Choti Chopar to Badi Chopar (Down Line)

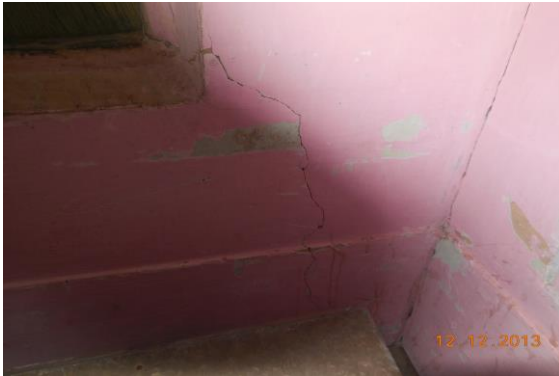
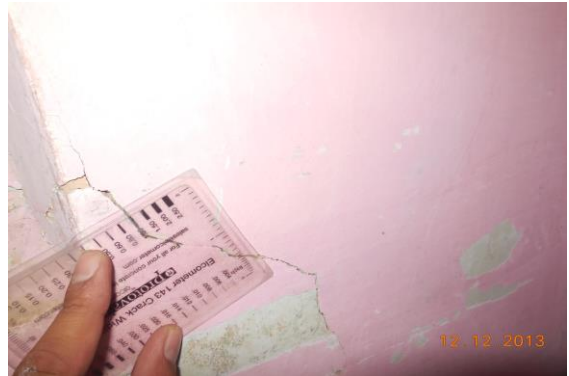
Photo 6

Inclined Crack on Floor of Room No. 1, House No. 424 Part A, Second Floor, Approx. Width = 1mm, Approx. Length = 1.3m. Distance from Wall No. 1 = 0.25m, Height from Floor = 0m.

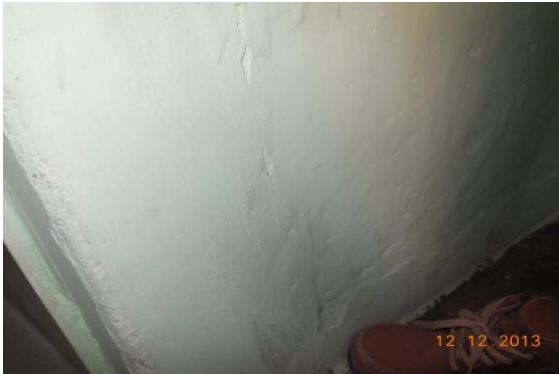
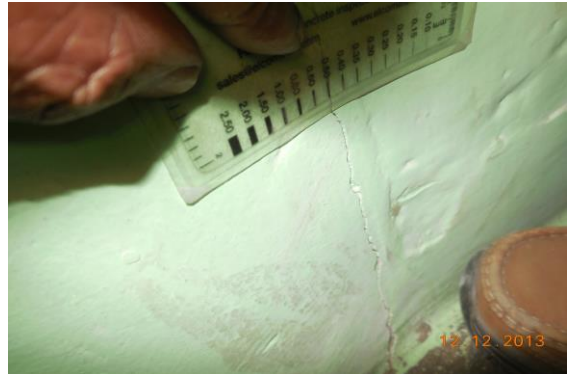
Photo 7

Inclined Crack on Floor of Passage 1, House No. 424 Part A, First Floor, Approx. Width = 0.5mm, Approx. Length = 1.5m. Distance from Wall No. 4 = 0.7m, Height from Floor = 0m.

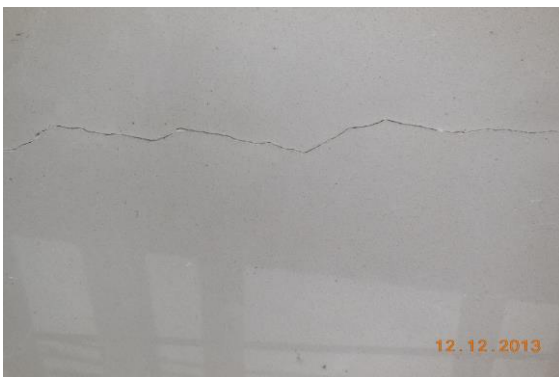
Photo 8

Horizontal Crack on Roof of Room No. 3, First Floor, Approx. Width = 0.8mm, Approx. Length = 2.5m. Distance from Wall No. 4 = 0m, Height from Floor = 2.5m.

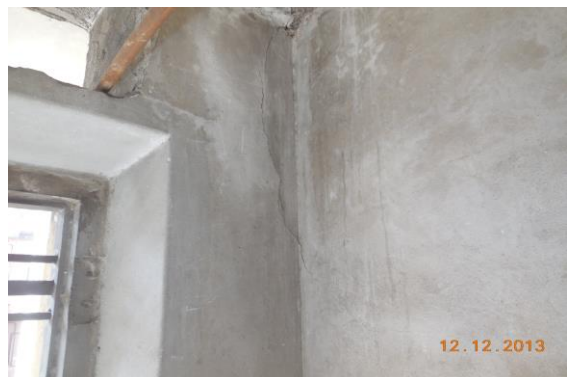
Photo 9

Inclined Crack on Roof of Room No. 3, First Floor, Approx. Width = 0.8mm, Approx. Length = 0.8m. Distance from Wall No. 3 = 2.5m, Height from Floor = 1.8m.

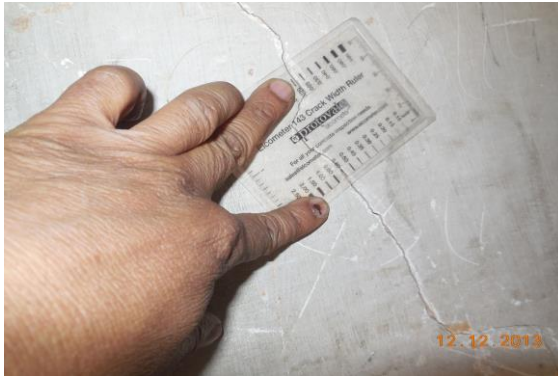
Photo 10

Inclined Crack on Roof of Open Area, House No. 424 Part A, Ground Floor, Approx. Width = 0.6mm, Approx. Length = 1m. Distance from Wall No. 1 = 1.5m, Height from Floor = 1m.

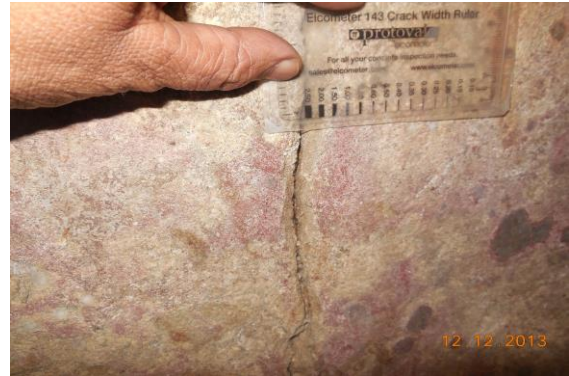
Photo 11

Inclined Crack on Roof of Passage 1, House No. 424 Part A, Ground Floor, Approx. Width = 2.5mm, Approx. Length = 1.7m. Distance from Wall No. 3 = 1.05m, Height from Floor = 0m.

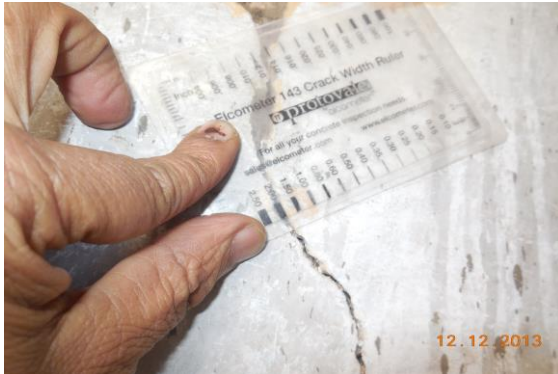
Photo 12

Inclined Crack on Roof of Passage 1, House No. 424 Part A, Ground Floor, Approx. Width = 2mm, Approx. Length = 1m. Distance from Wall No. 1 = 3m, Height from Floor = 1.2m.

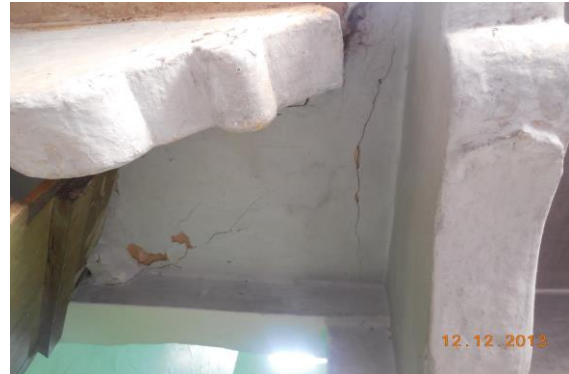
Photo 13

Inclined Crack on Roof of Open Area, House No. 424 Part A, Ground Floor, Approx. Width = 0.5mm, Approx. Length = 0.6m. Distance from Wall No. 1 = 0.6m, Height from Floor = 2.4m.

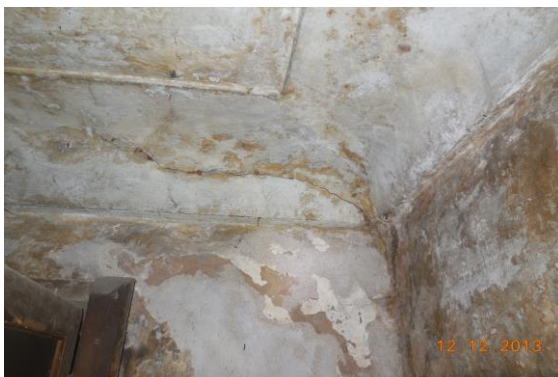
Photo 14

Inclined Crack on Roof of Room No. 4, House No. 424 Part A, Ground Floor, Approx. Width = 1mm, Approx. Length = 0.6m. Distance from Wall No. 4 = 0m, Height from Floor = 2m.

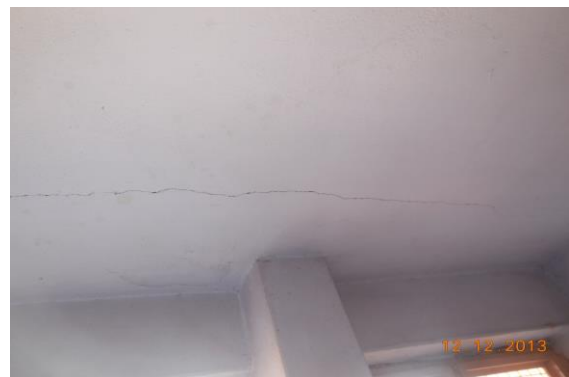
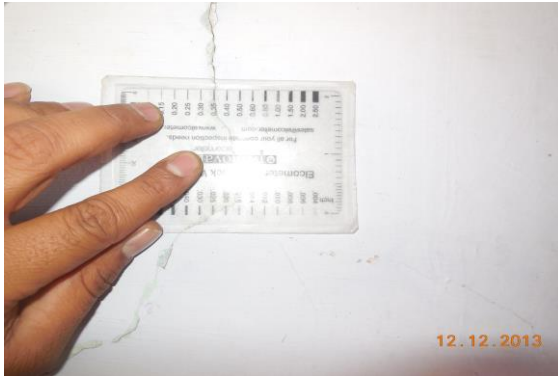
Photo 15

Inclined Crack on Wall No.2 & Roof of Room No. 1, House No. 424 Part A, Third Floor, Approx. Width = 0.35mm, Approx. Length = 2.6m. Distance from Wall No. 4 = 1.45m, Height from Floor = 1.8m.

Inclined Crack on Wall No. 2& Roof of Room No. 1, House No. 424 Part A, Third Floor, Approx. Width = 0.35mm, Approx. Length = 2.6m. Distance from Wall No. 4 = 1.45m, Height from Floor = 1.8m.

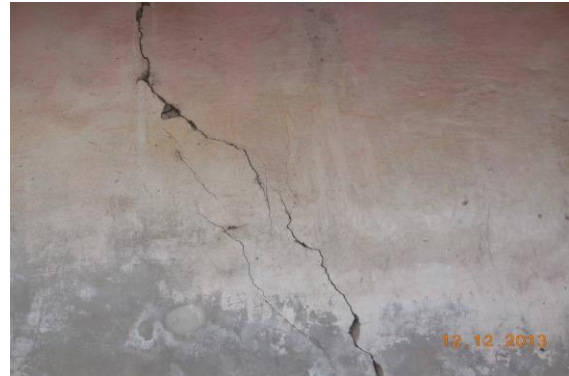
Photo 16

Inclined Crack on Wall No. 2& Roof, Ground Floor, Approx. Width = 10mm, Approx. Length = 3m. Distance from Wall No. 1 = 5.5m, Height from Floor = 0m.

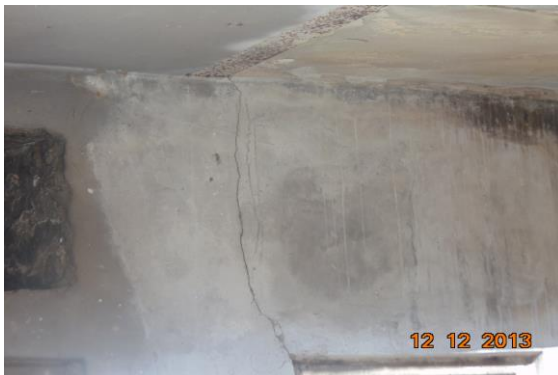
Photo 17

Inclined Crack on Wall No. 2& Roof of Right Side Of Building, House No. 424 Part A, Ground Floor, Approx. Width = 1.5mm, Approx. Length = 3m. Distance Wall No. 3 = 6m, Height Floor = 2m.

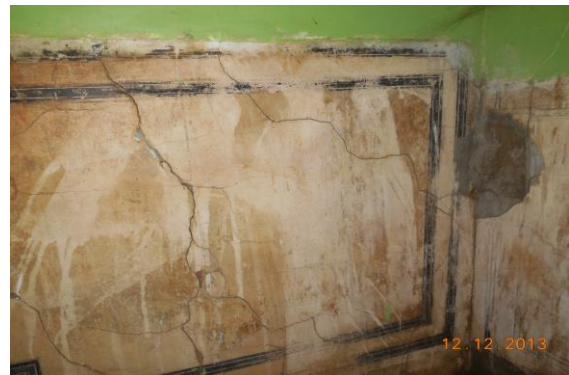
Photo 18

Damaged Portion of House No. 424 Part A of Second Floor

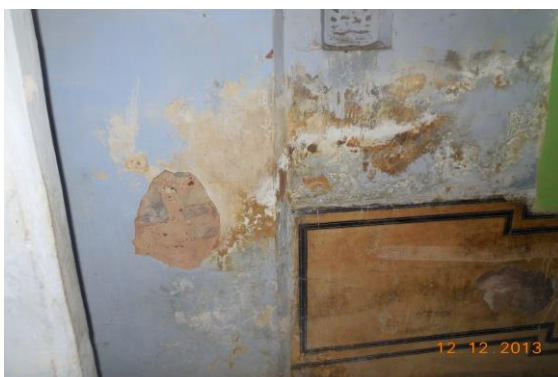
Photo 19

Dampness/Seepage of Stair Case of House No. 424 Part A, Second Floor

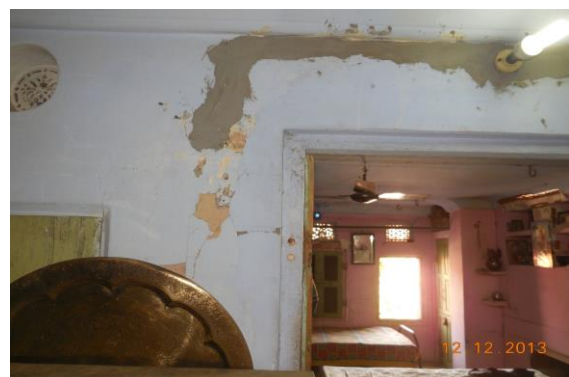
Photo 20

Damaged Portion of Passage 1 of House No. 424 Part A, Second Floor

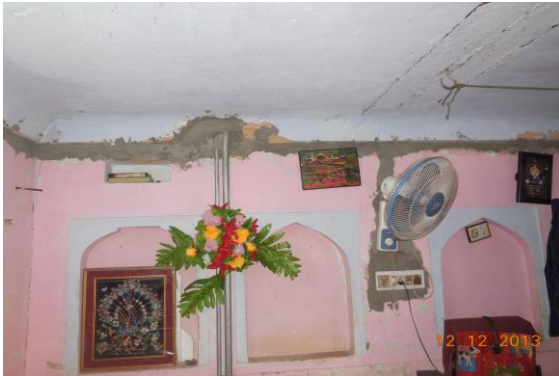
Photo 21

Damaged Portion of Room No. 1 of House No. 424 Part A, Second Floor

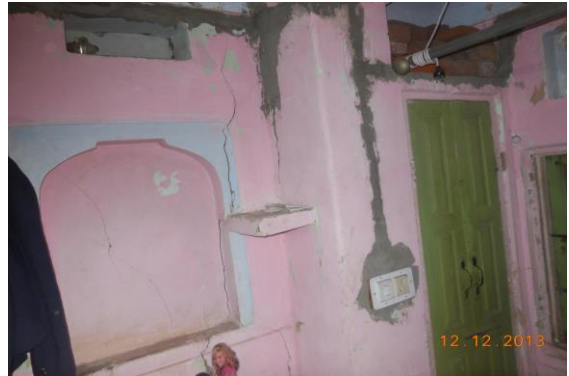
Photo 22

Damaged Portion of Room No. 1 of House No. 424 Part A, Second Floor

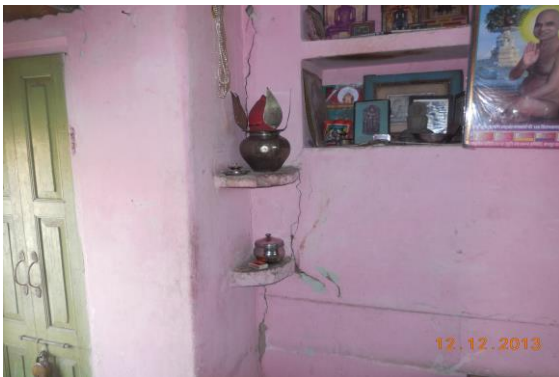
Photo 23

Damaged Portion of Room No. 1 of House No. 424 Part A, Second Floor

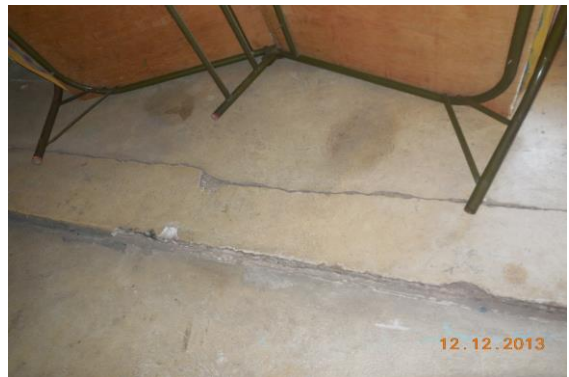
Photo 24

Damaged Portion on Floor of Room No. 1 of House No. 424 Part A, Second Floor

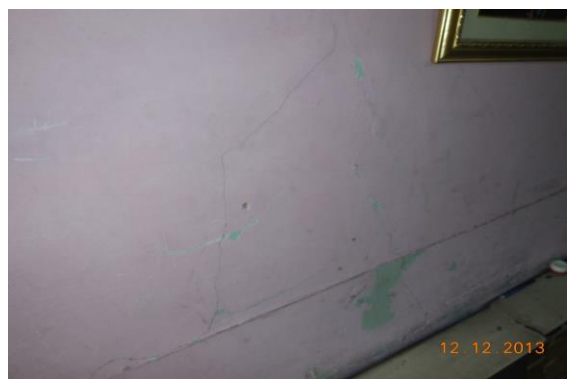
Photo 26

Peeling of Plaster on Roof of Room No. 1 of House No. 424 Part A, Second Floor

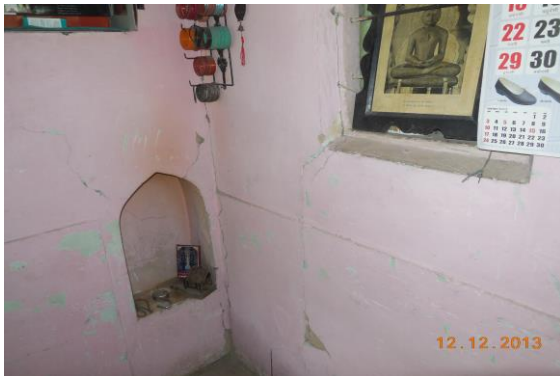
Photo 27

Damaged Portion on Roof of Room No. 1 of House No. 424 Part A, Second Floor

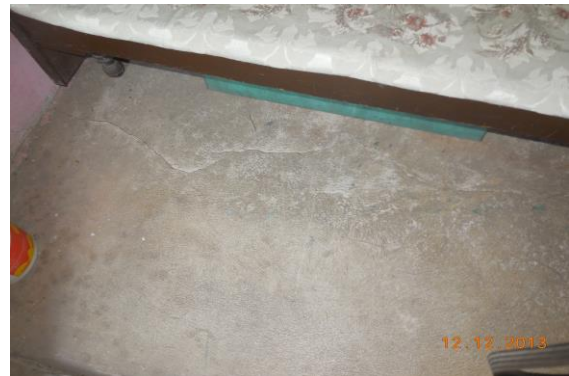
Photo 28

Plaster Crack on Floor of Room No. 1 of House No. 424 Part A, Second Floor

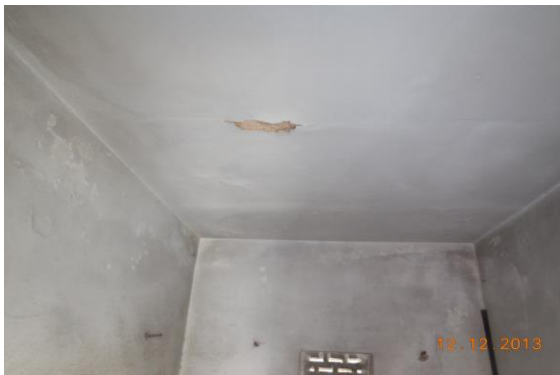
Photo 29

Peeling of Plaster on Roof of Bathroom of House No. 424 Part A, Second Floor

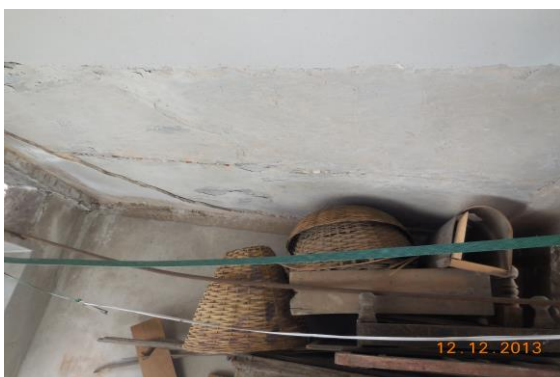
Photo 31

Peeling of Plaster on Roof of Room No. 3 of House No. 424 Part A, First Floor

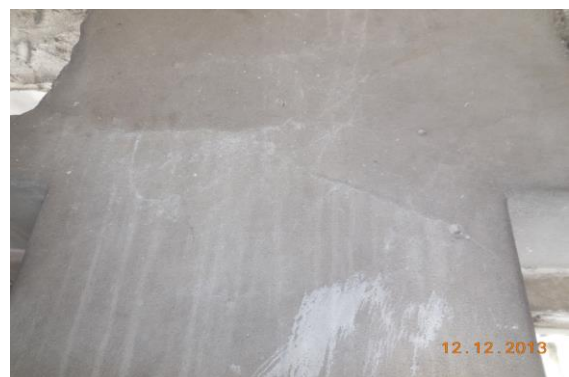
Photo 32

Plaster Crack on Roof of Room No. 3 of First Floor

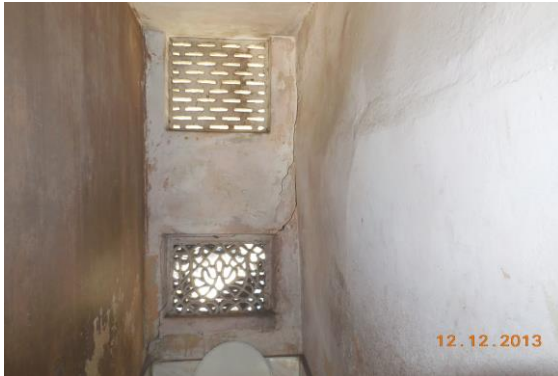
Photo 33

Damaged Portion on Roof of Bathroom of House No. 424 Part A, First Floor

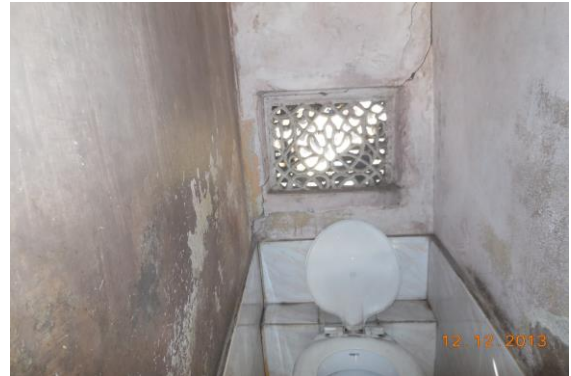
Photo 34

Damaged Portion on Roof of Bathroom of House No. 424 Part A, First Floor

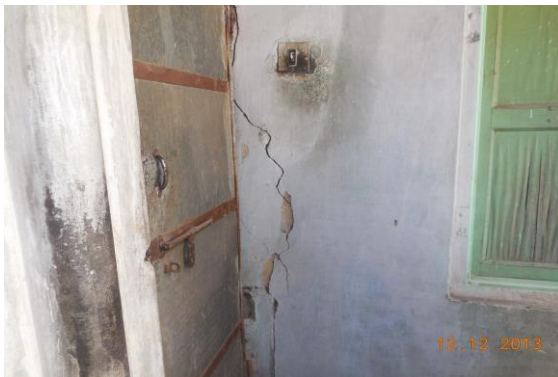
Photo 35

Dampness/Seepage on Roof of House No. 424 Part A of First Floor

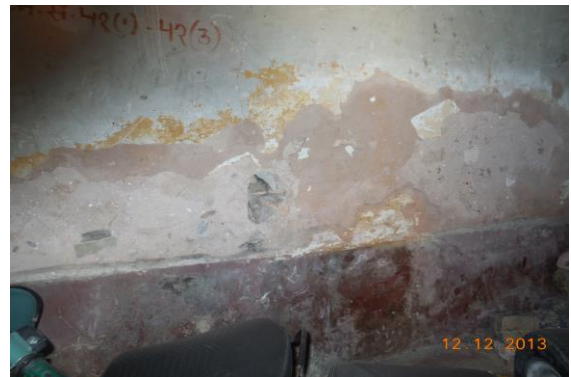
Photo 36

Damaged Portion on Roof of Balcony 1 of House No. 424 Part A, Ground Floor

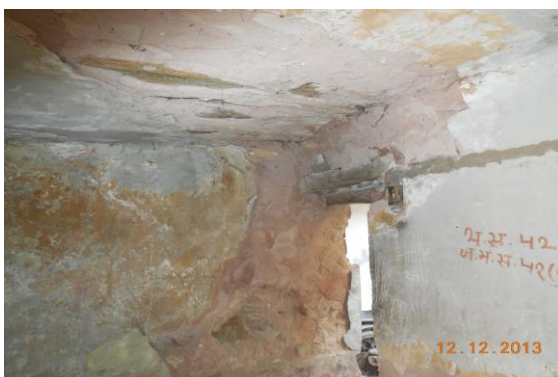
Photo 37

Damaged Portion on Roof of Passage 1 of House No. 424 Part A, Ground Floor

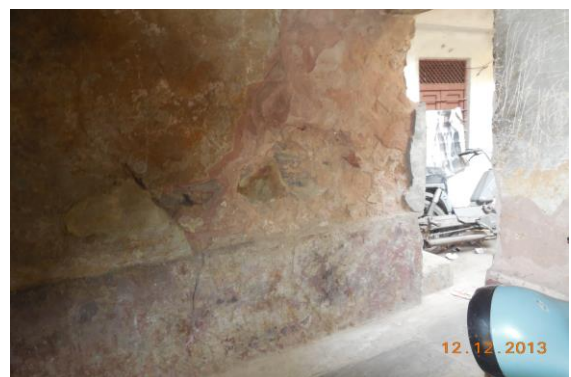
Photo 38

Damaged Portion on Roof of Passage 1 of House No. 424 Part A, Ground Floor

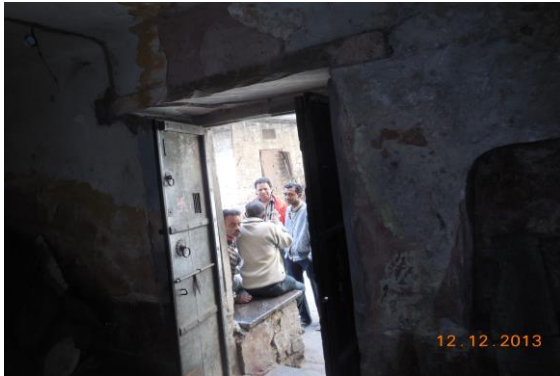
Photo 39
Peeling of Plaster on Roof of Passage 1 of House No. 424 Part A,
Ground Floor

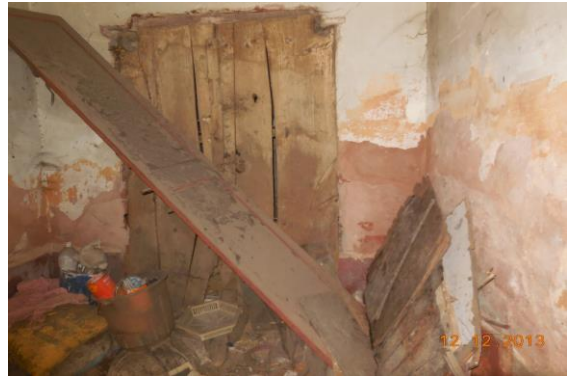
Photo 40
Peeling of Plaster on Roof of Passage 1 of House No. 424 Part A,
Ground Floor

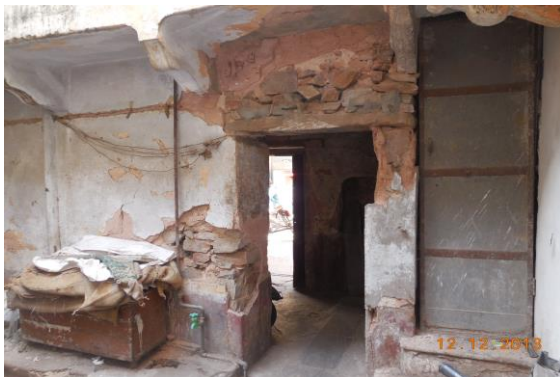
Photo 41
Damaged Portion on Roof of Passage 1 of House No. 424 Part A,
Ground Floor

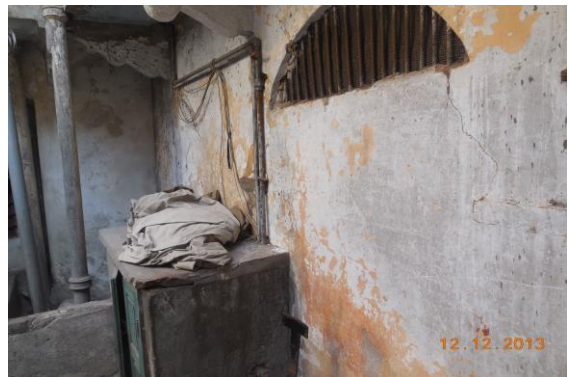
Photo 42
Peeling of Plaster on Roof of Open Area of House No. 424 Part A,
Ground Floor

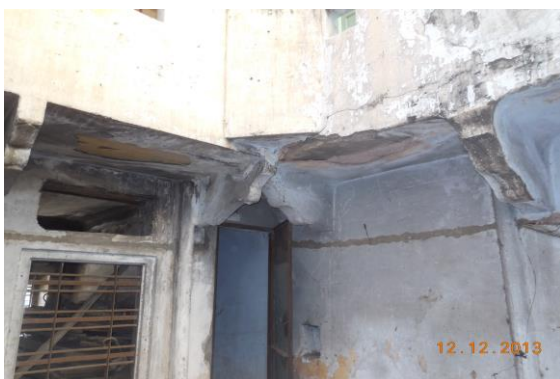
Photo 43
Peeling of Plaster on Sunshade of Open Area of House No. 424 Part A,
Ground Floor

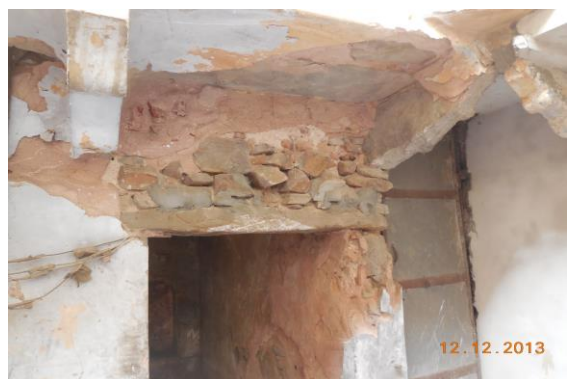
Photo 44
Peeling of Plaster on Sunshade of Open Area of House No. 424 Part A,
Ground Floor

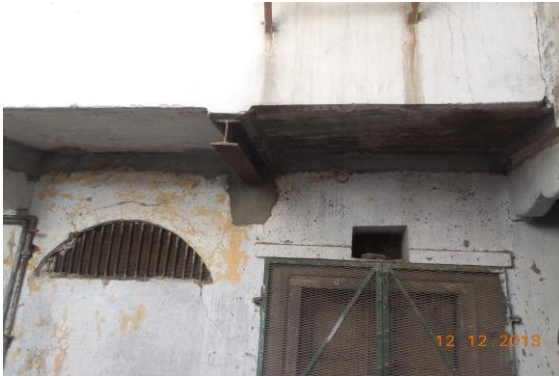
Photo 45

Peeling of Plaster on Sunshade of Open Area of House No. 424 Part A, Ground Floor

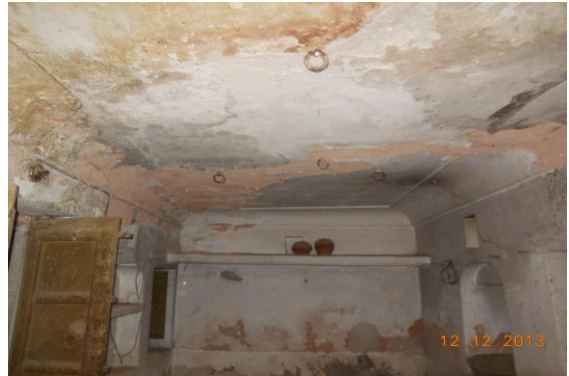
Photo 46

Peeling of Plaster on Roof of Room No. 4 of House No. 424 Part A, Ground Floor

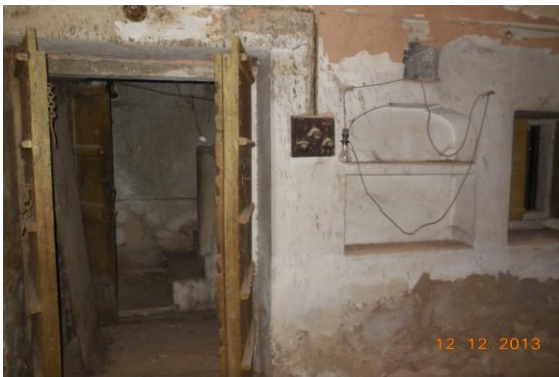
Photo 47

Peeling of Plaster on Roof of Room No. 4 of House No. 424 Part A, Ground Floor

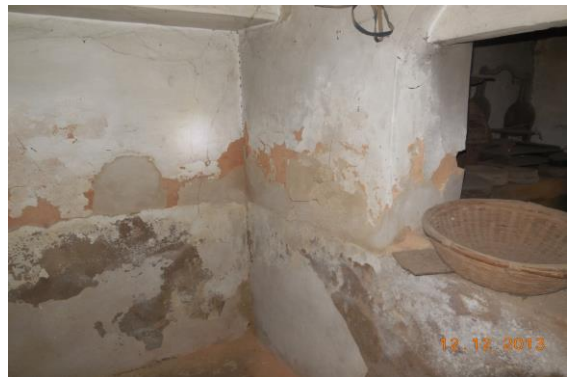
Photo 48

Damaged Portion on Roof of Room No. 4 of House No. 424 Part A, Ground Floor

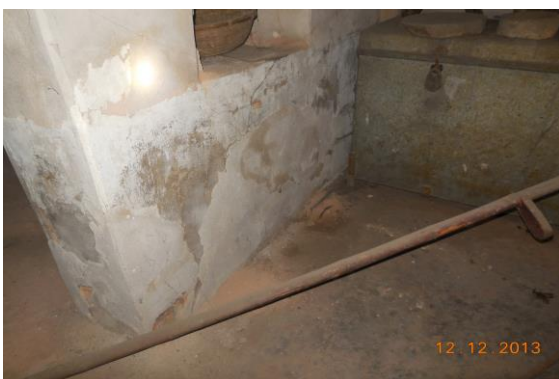
Photo 49

Damaged Portion on Roof of Room No. 3 of House No. 424 Part A, Ground Floor

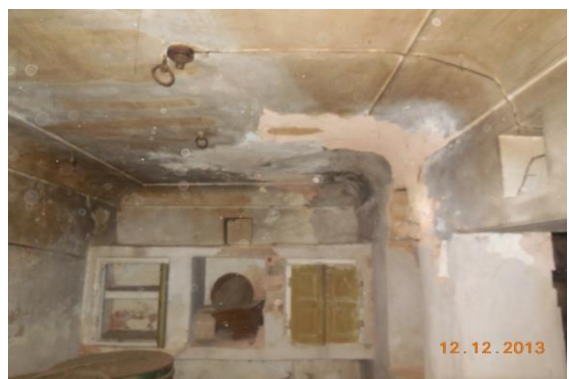
Photo 50

Damaged Portion on Wall No. 1&4&Roof of Room No. 3 of House No. 424 Part A, Ground Floor

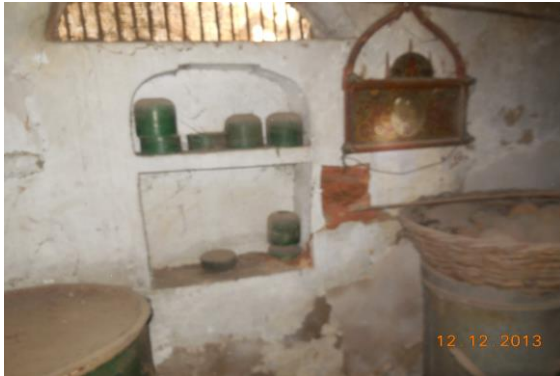
Photo 51

Damaged Portion on Wall No. 1,4 & Roof of Room No. 3 of House No. 424 Part A, Ground Floor

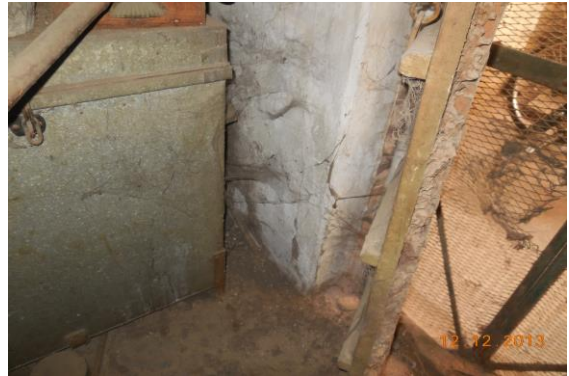
Photo 52

Damaged Portion on Wall No. 1,4 & Roof of Room No. 3 of House No. 424 Part A, Ground Floor

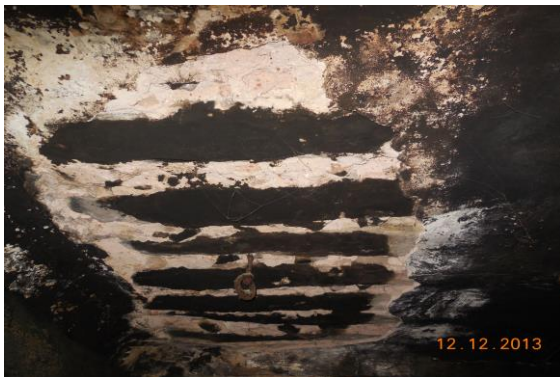
Photo 53

Damaged Portion on Roof of Room No. 2 of House No. 424 Part A, Ground Floor

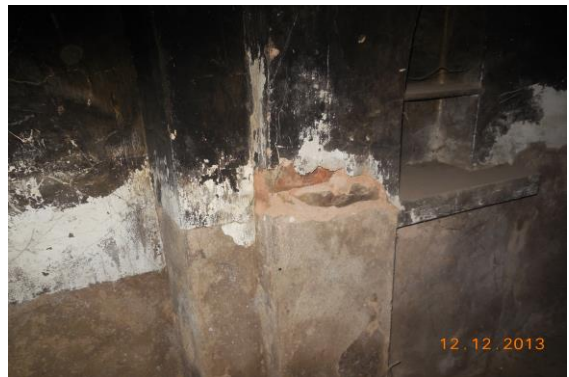
Photo 54

Damaged Portion on Roof of Room No. 2 of House No. 424 Part A, Ground Floor

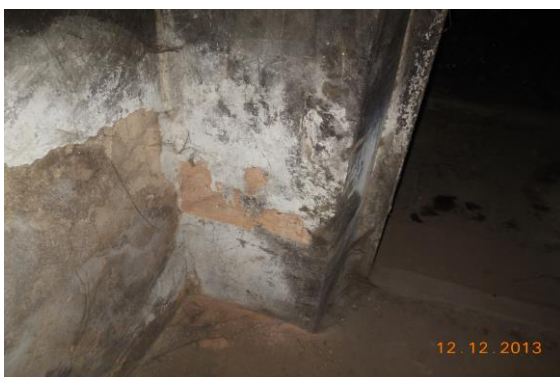
Photo 55

Damaged Portion on Roof of Room No. 2 of House No. 424 Part A, Ground Floor

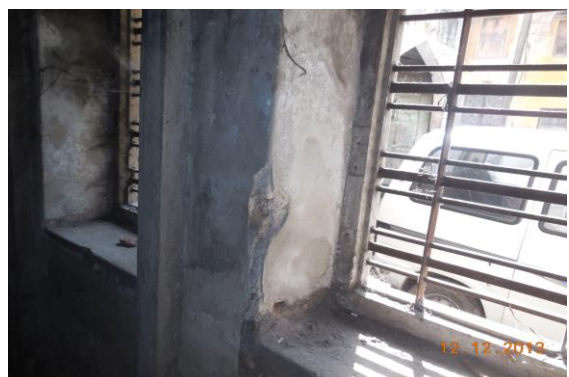
Photo 56

Damaged Portion on Roof of Room No. 1 of House No. 424 Part A, Ground Floor

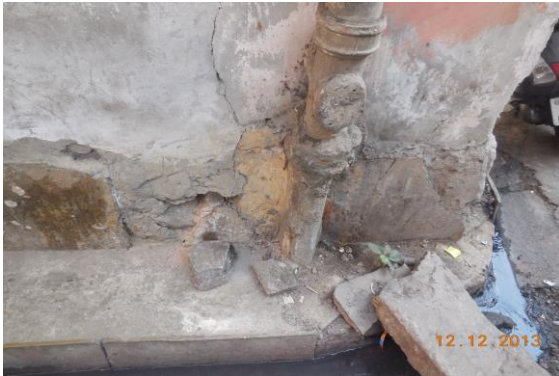
Photo 57

Damaged Portion on Wall No.2 & Roof of Front Side Of Building of House No. 424 Part A, Ground Floor

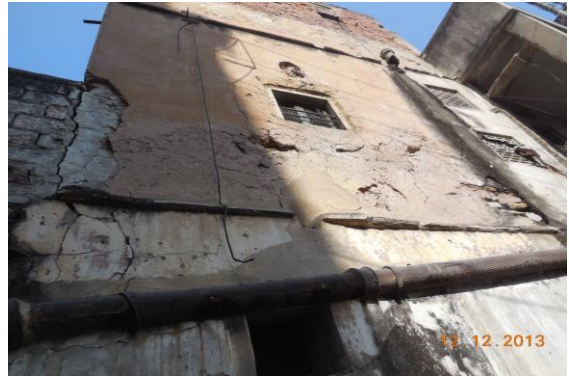
Photo 58

Damaged Portion on Wall No. 2 & Roof of Front Side Of Building of House No. 424 Part A, Ground Floor

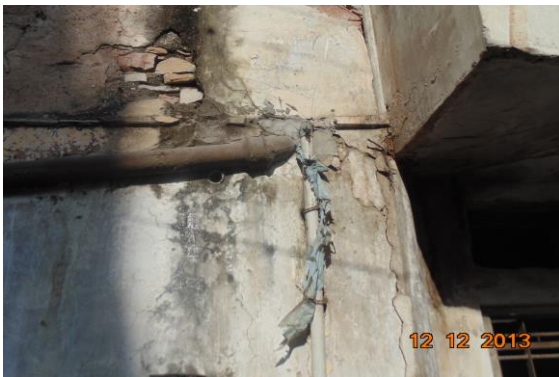
Photo 59

Damaged Portion on Wall No. 2 & Roof of Outer Side on GF of House No. 424 Part A, Ground Floor

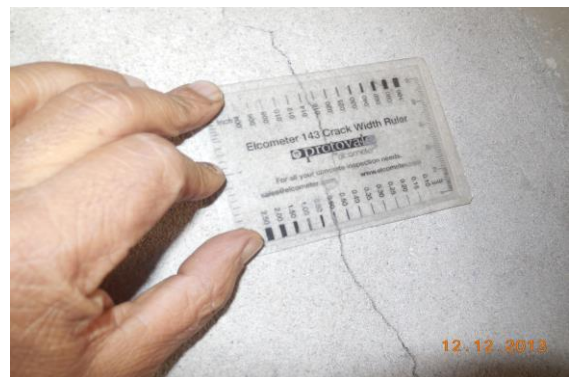
Photo 5A
Inclined Crack on of Stair Case FF to SF, House No. 423, First Floor, Approx. Width = 0.6mm, Approx. Length = 1.3m. Distance from Wall No. 1 = 0.9m, Height from Floor = 1m.

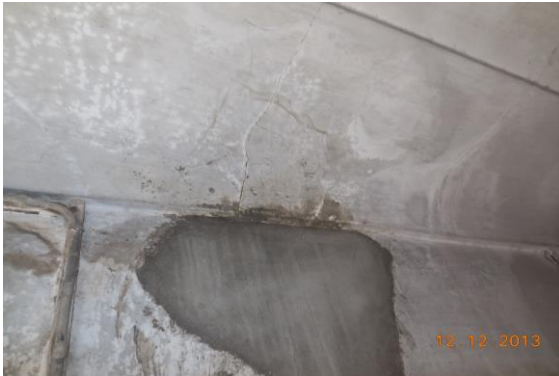
Photo 6

Inclined Crack on Roof of Passage 1, House No. 423, First Floor, Approx. Width = 0.5mm, Approx. Length = 1.1m. Distance from Wall No. 1 = 2.5m, Height from Floor = 2.5m.

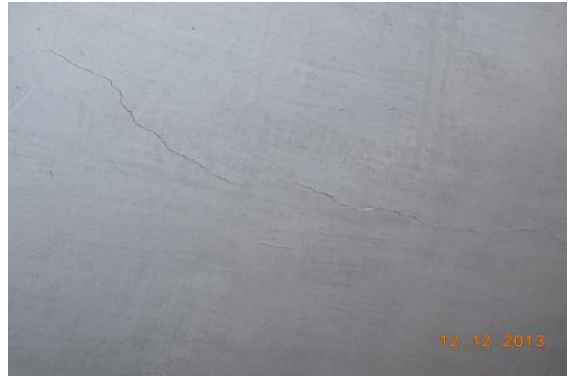
Photo 7

Inclined Crack on Roof of Passage 1, House No. 423, First Floor, Approx. Width = 0.3mm, Approx. Length = 2m. Distance from Wall No. 1 = 2.8m, Height from Floor = 2.5m.

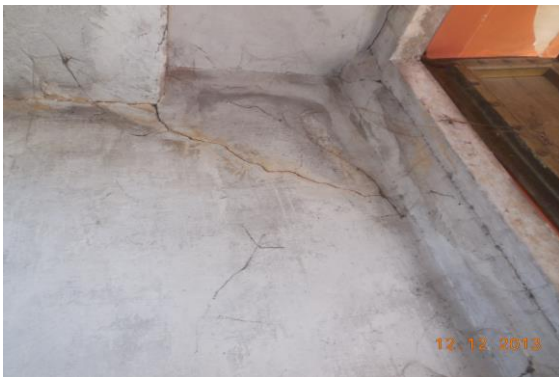
Photo 8

Inclined Crack on Roof of Passage 1, House No. 423, First Floor, Approx. Width = 1.5mm, Approx. Length = 1.5m. Distance from Wall No. 3 = 0m, Height from Floor = 1.8m.

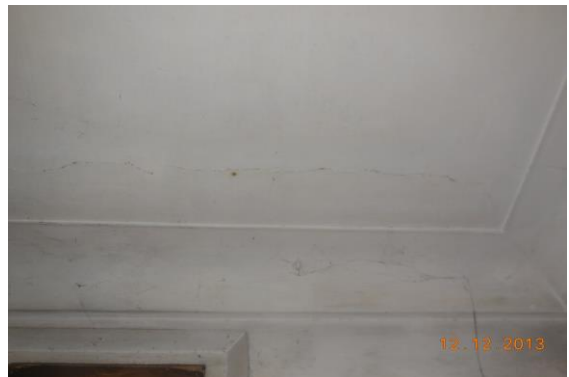
Photo 9

Inclined Crack on Roof of Room No. 4, House No. 423, Second Floor, Approx. Width = 1mm, Approx. Length = 2m. Distance from Wall No. 3 = 0m, Height from Floor = 3m.

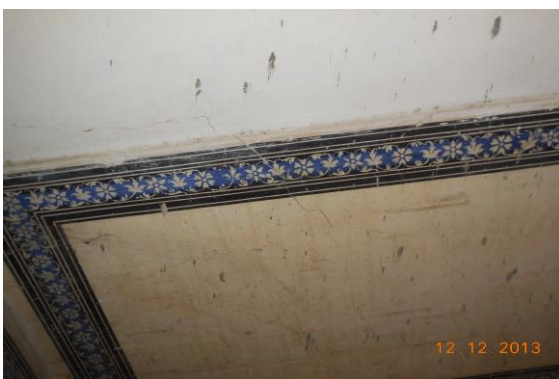
Photo 10

Inclined Crack on Roof of Room No. 4, House No. 423, Second Floor, Approx. Width = 0.3mm, Approx. Length = 1.1m. Distance from Wall No. 4 = 1.6m, Height from Floor = 0.4m.

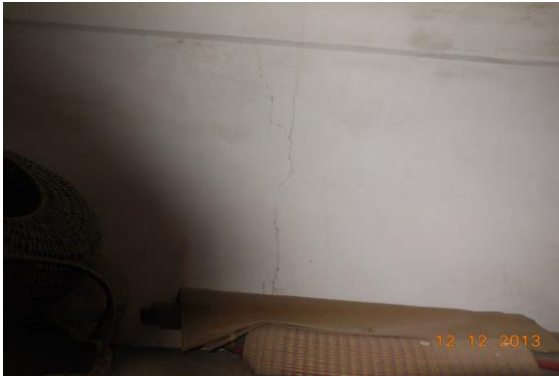
Photo 11

Inclined Crack on Roof of Kitchen, House No. 423, First Floor, Approx.
Width = 0.25mm, Approx. Length = 0.95m.
Distance from Wall No. 3 = 0.6m, Height from Floor = 1.5m.

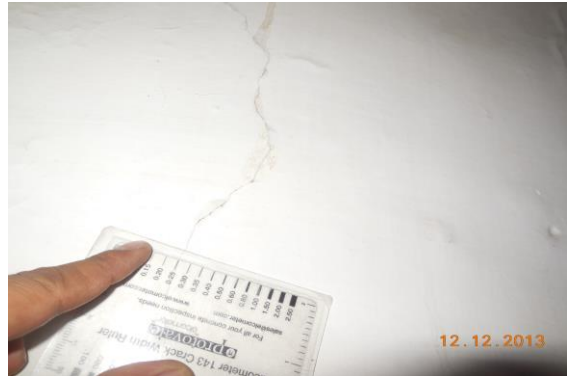
Photo 11A

Inclined Crack on Roof of Kitchen, House No. 423, First Floor, Approx.
Width = 0.25mm, Approx. Length = 0.95m.
Distance from Wall No. 3 = 0.6m, Height from Floor = 1.5m.

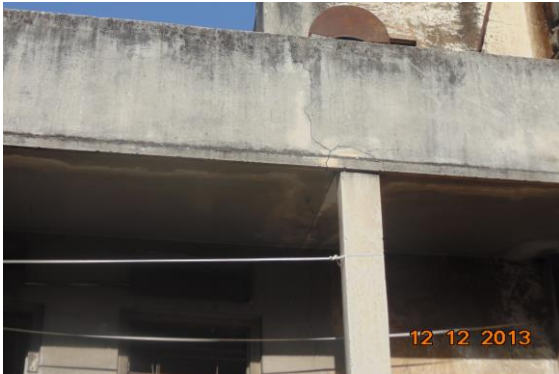
Photo 12

Inclined Crack on Roof of Balcony, House No. 423, First Floor, Approx.
Width = 1.5mm, Approx. Length = 3.2m.
Distance from Wall No. 4 = 1.5m, Height from Floor = 5m.

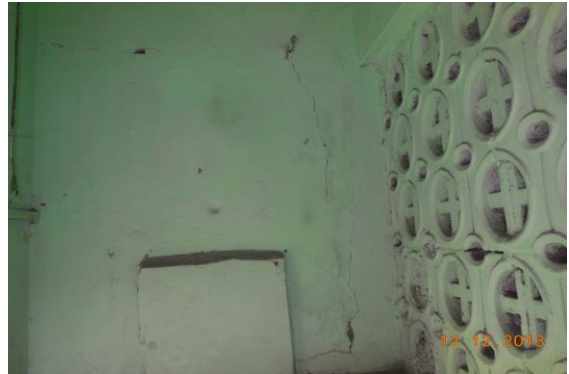
Photo 13

Inclined Crack on wall of Bathroom, House No. 423, First Floor, Approx.
Width = 0.5mm, Approx. Length = 2m.
Distance from Wall No. 1 = 0m, Height from Floor = 1m.

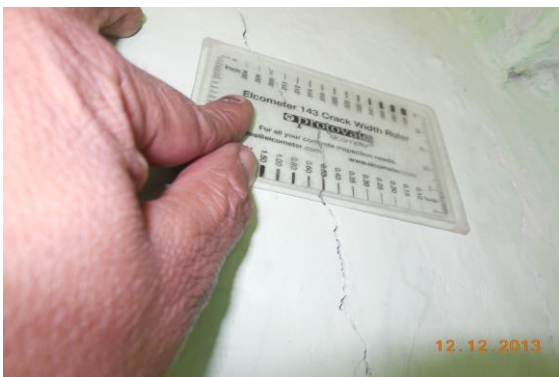
Photo 13A

Inclined Crack on wall of Bathroom, House No. 423, First Floor, Approx.
Width = 0.5mm, Approx. Length = 2m.
Distance from Wall No. 1 = 0m, Height from Floor = 1m.

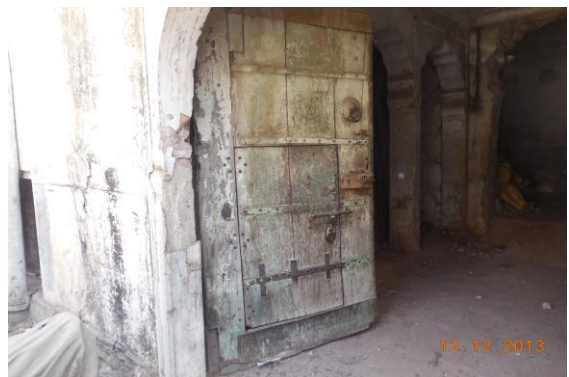
Photo 14

Damaged Portion on Entry Gate of House No. 423, Ground Floor

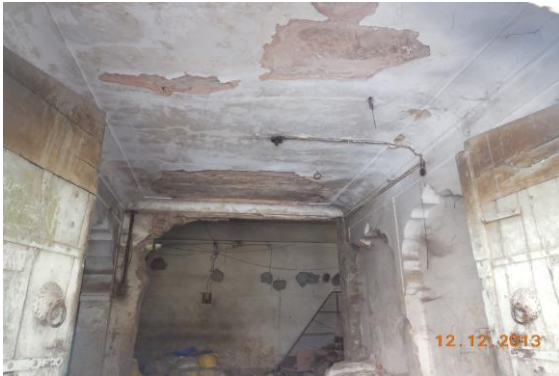
Photo 15

Damaged Portion on Roof of Passage 1 of House No. 423, Ground Floor

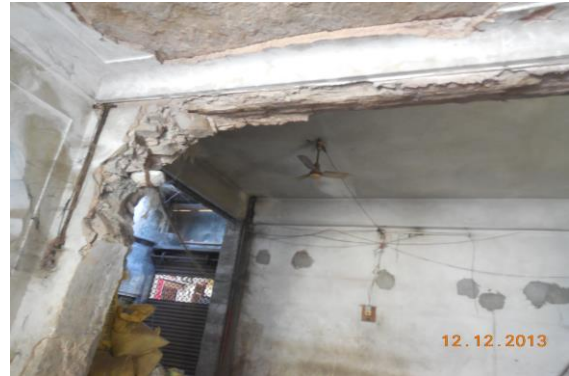
Photo 16

Damaged Portion on Roof of Hall No. 1 of House No. 423, Ground Floor

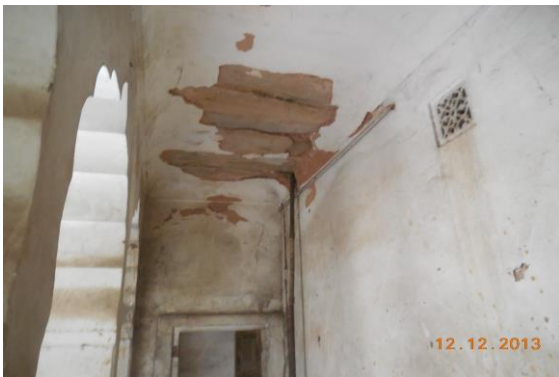
Photo 17

Damaged Portion on Roof of Varanda of House No. 423, Ground Floor

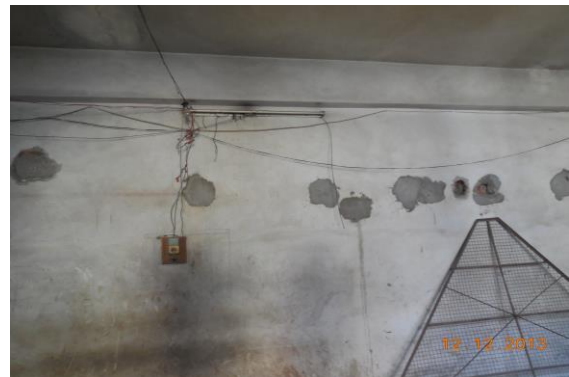
Photo 18

Peeling of Plaster on Roof of Hall No. 1 of House No. 423, Ground Floor

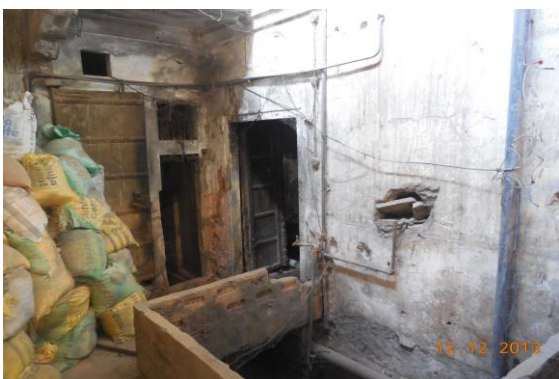
Photo 19

Damaged Portion on Roof of Hall No. 1 of House No. 423, Ground Floor

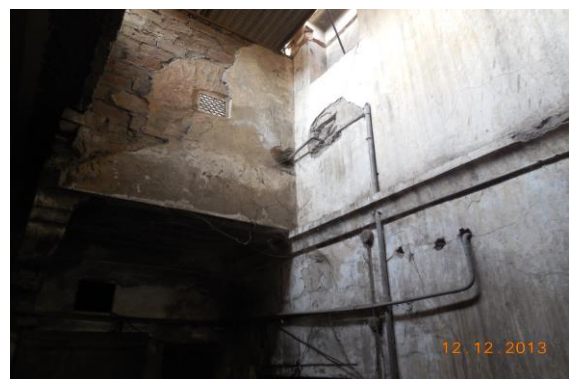
Photo 20

Damaged Portion on Roof of Hall No. 1 of House No. 423, Ground Floor

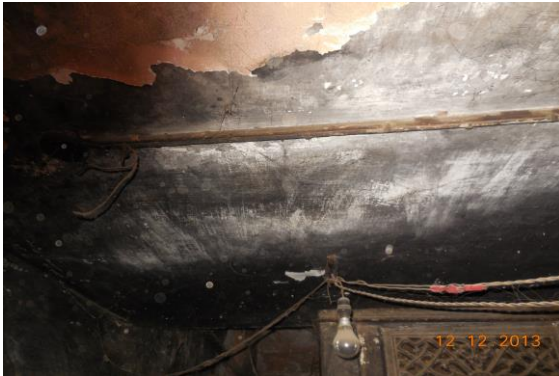
Photo 21

Dampness/Seepage on Roof of Passage 1 of House No. 423, Ground Floor

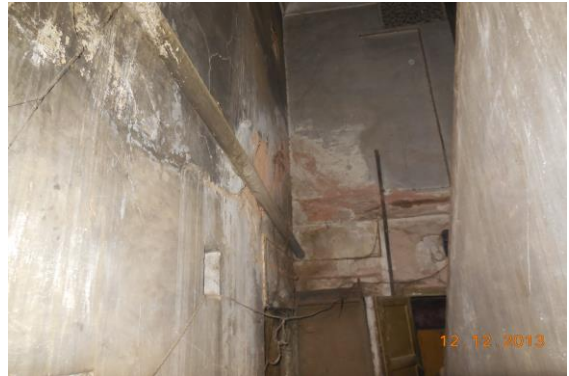
Photo 22

Peeling of Plaster on Roof of Passage 1 of House No. 423, Ground Floor

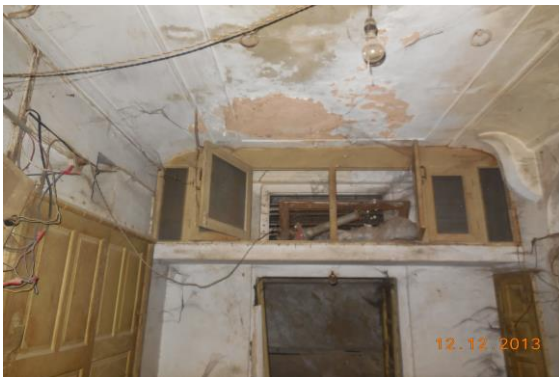
Photo 23

Peeling of Plaster on Roof of Room No. 1 of House No. 423, Ground Floor

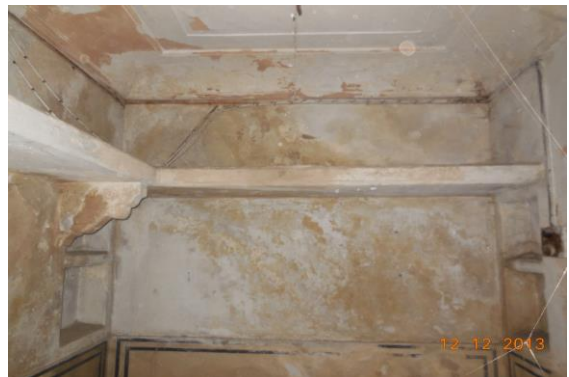
Photo 24

Dampness/Seepage on Wall No. 1&2& Roof of Room No. 2 of House No. 423, Ground Floor

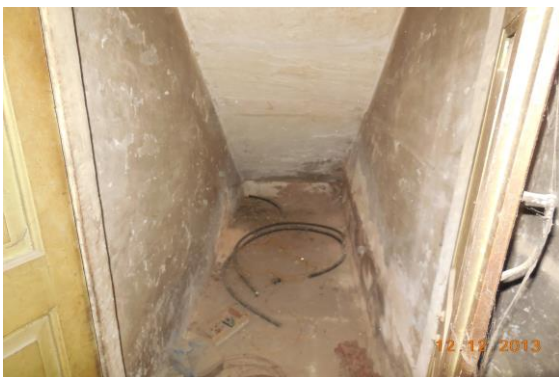
Photo 25

Dampness/Seepage on Wall No. 1&2 & Roof Store 1 of House No. 423, Ground Floor

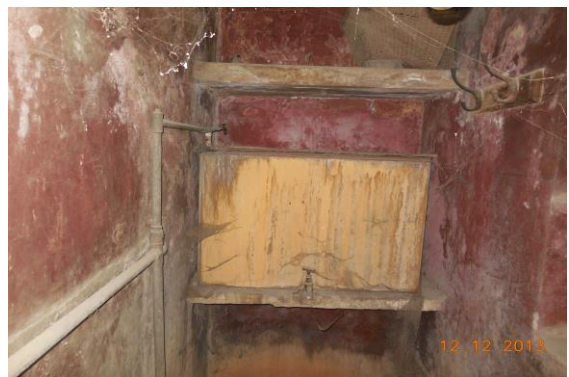
Photo 26

Dampness/Seepage on Wall No.1&2& Roof, Store 2 of House No. 423, Ground Floor

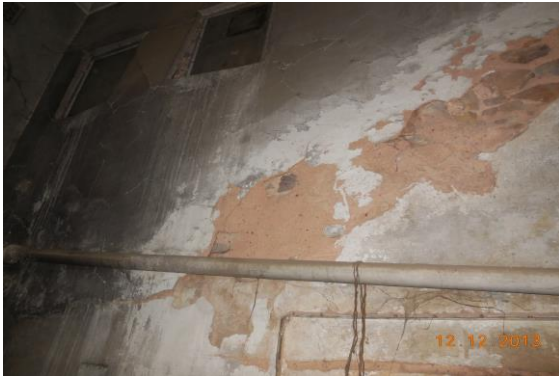
Photo 27

Damaged Portion on Wall No.1&2 & Roof, Passage 3 of House No. 423, Ground Floor

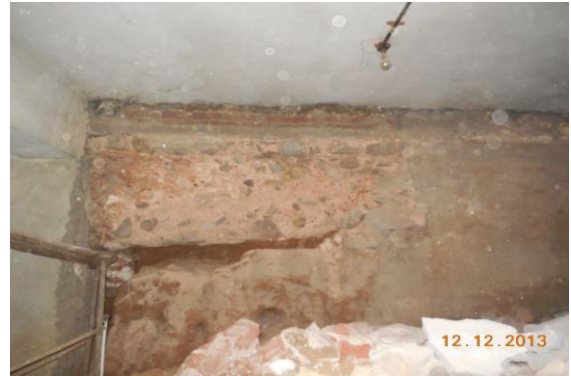
Photo 28

Damaged Portion on Wall No. 1&2 & Roof of House No. 423, Basement

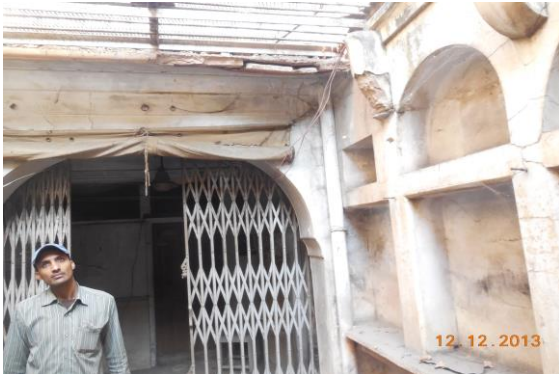
Photo 29

Damaged Portion on Wall No.1 & Shade of Sky Open Lobby of House No. 423, First Floor

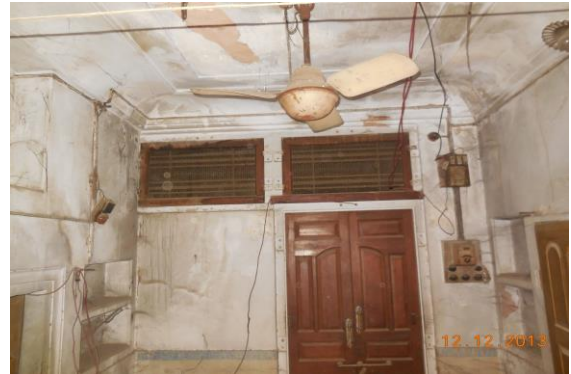
Photo 30

Damaged Portion on Wall No. 4 & Roof of Lobby of House No. 423, First Floor

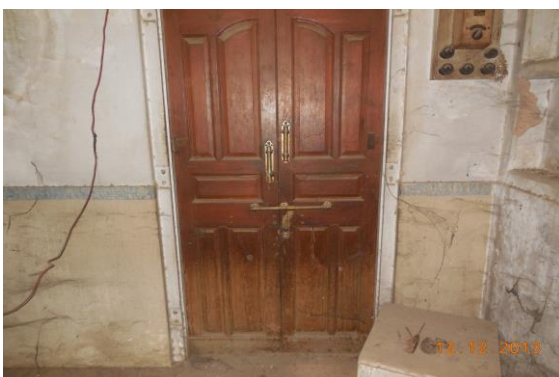
Photo 31

Damaged Portion on of House No. 423 of First Floor

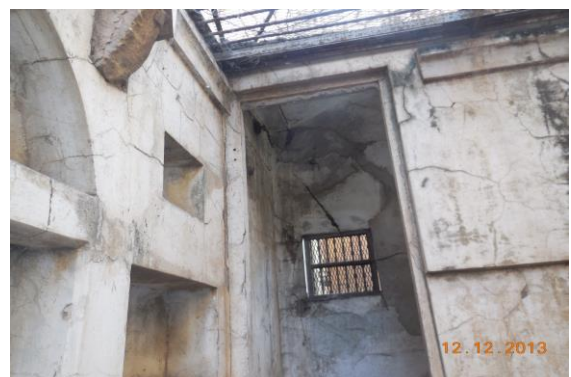
Photo 32

Peeling of Plaster of Stair Case FF to SF of House No. 423, First Floor

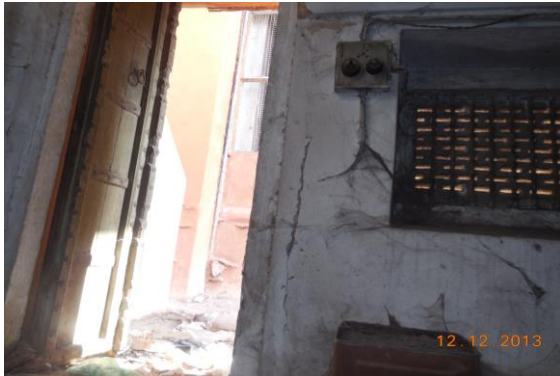
Photo 33

Plaster Crack on Roof of Passage 1 of House No. 423, First Floor

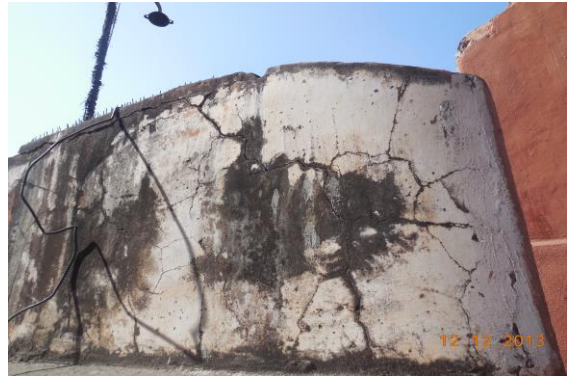
Photo 34

Plaster Crack on Roof of House No. 423 of First Floor

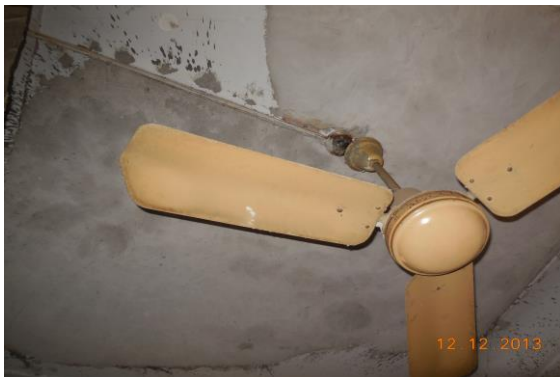
Photo 35

Peeling of Plaster on Roof of Room No. 4 of House No. 423, Second Floor

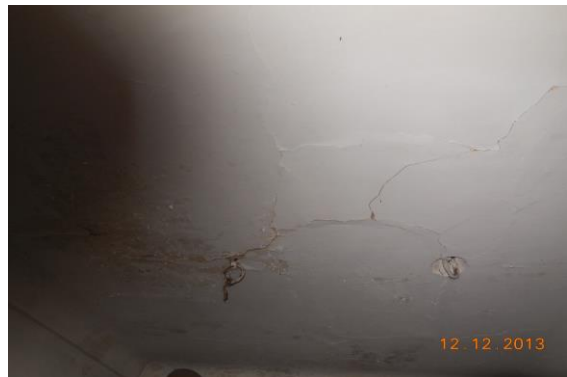
Photo 36

Damaged Portion on Roof of Kitchen of House No. 423, First Floor

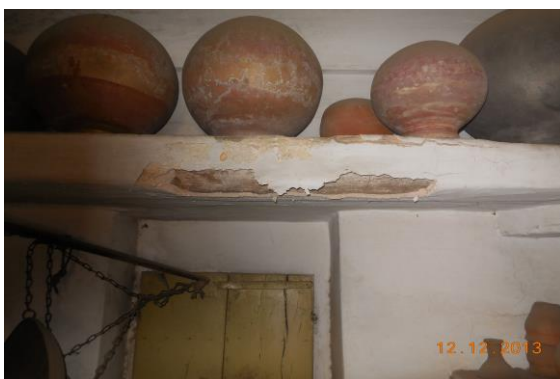
Photo 37

Damaged Portion on Roof of Kitchen of House No. 423, First Floor

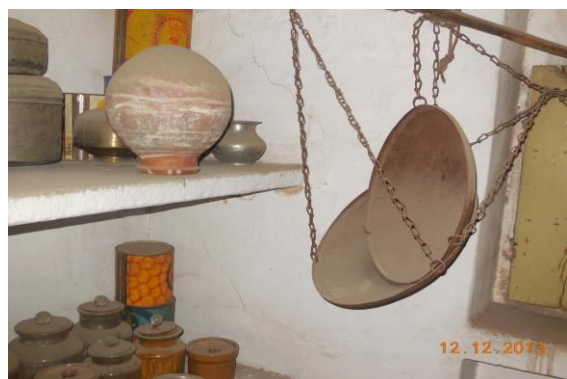
Photo 38

Plaster Crack on Roof of Kitchen of House No. 423, First Floor

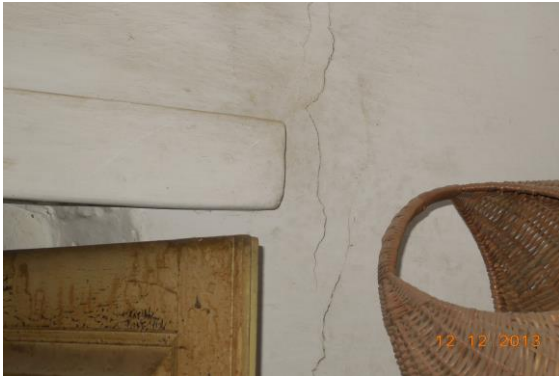
Photo 39
Plaster Crack on Roof of Kitchen of House No. 423, First Floor

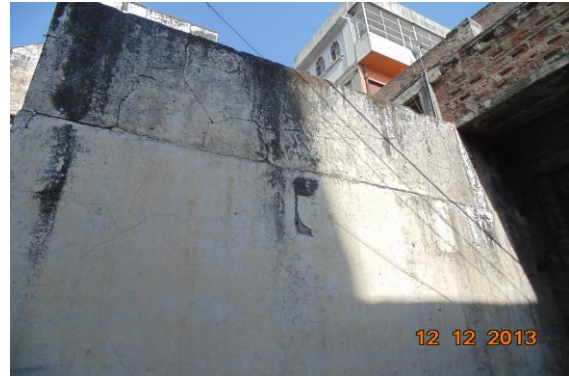
Photo 40
Damaged Portion on Roof of House No. 423 of Ground Floor

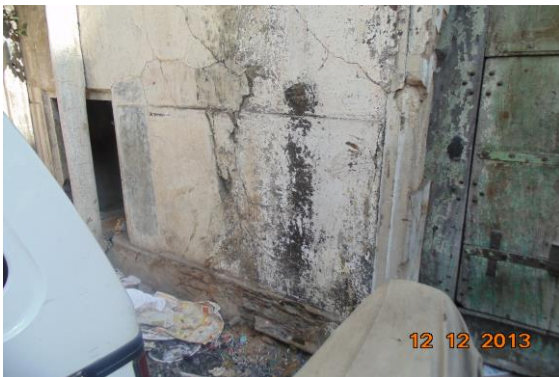
Photo 41
Damaged Portion on Roof of Left Side of Ground Floor

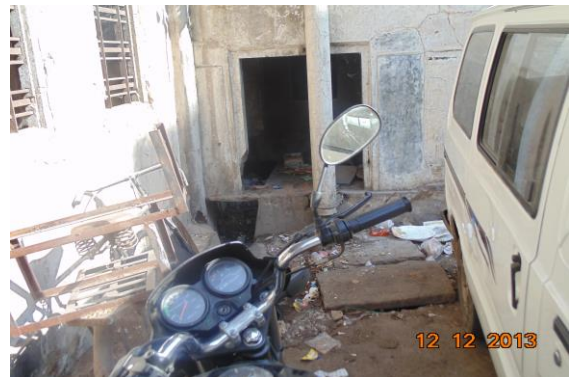
Photo 42
Damaged Portion on Roof of Left Side of Ground Floor
