Pre Building Condition Survey Report

Name and Address of Structure :	Choti Chopar to Badi Chopar (Down Line)
---------------------------------	---

Name of the Project	Contract JMRC-UG1B “Design and Construction of Tunnel between Chandpole and Badi Chouper and reverse line by Shield TBM, Underground Metro Stations at Choti Chouper and Badi Chouper by Cut and Cover Methods on East West Corridor of Jaipur Metro Rail Corporation Limited .”	
Owner :

Pre Building Condition Survey Report Choti Chopar to Badi Chopar (Down Line)

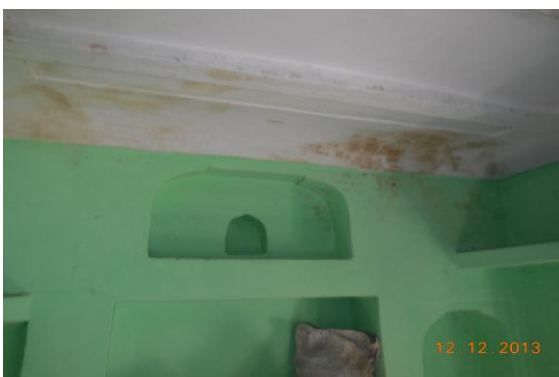
Photo 43
Dampness/Seepage on Wall No. 1 & Roof of Room No. 4 of House No. 423, First Floor

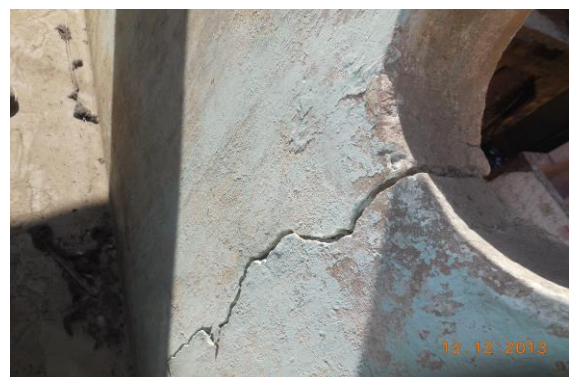
Photo 44
Damaged Portion of Balcony of House No. 423, First Floor

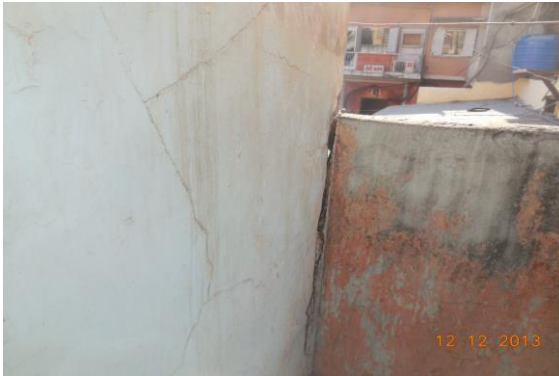
Photo 45

Damaged Portion of Balcony of House No. 423, First Floor

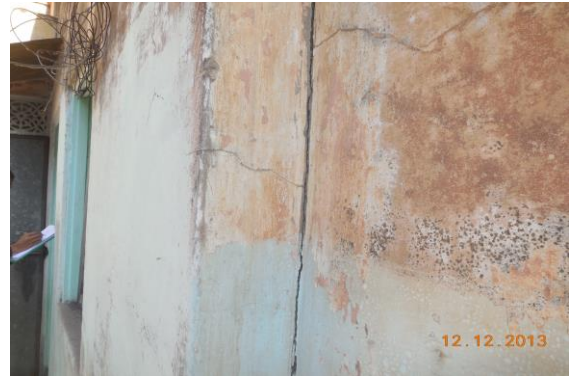
Photo 46

Damaged Portion of Balcony of House No. 423, First Floor

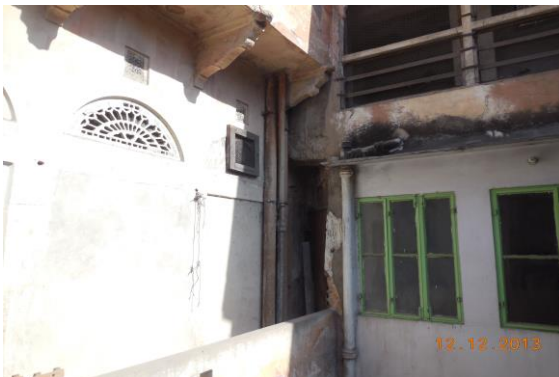
Photo 47

Damaged Portion of Open Sky Outer Side of House No. 423, First Floor

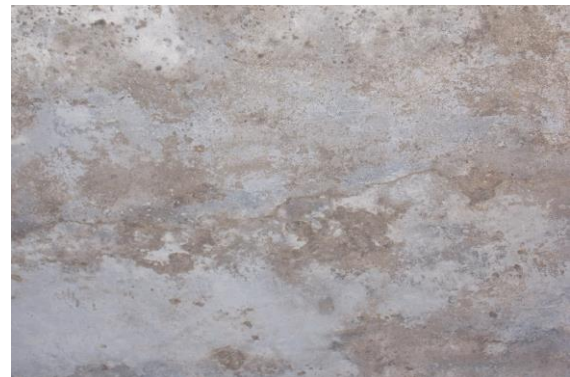
Summary of Cracks						
Defect ID	Location	Orientation	Appx. Width (mm)	Appx. Length (m)	Category	Photo No.
1	Roof Varanda of Shop no.195 Ground Floor	Horizontal	1	2.5	Slight	10
2	Roof Varanda of Shop No.195 Ground Floor	Horizontal	1	2.5	Slight	11
3	Roof Varanda of Shop No.195 Ground Floor	Horizontal	2	2.5	Slight	12
4	Roof Varanda of Shop No.195 Ground Floor	Horizontal	2	2.5	Slight	13
5	Beam Varanda of Shop No.197 Ground Floor	Horizontal	0.6	3.5	Very Slight	14

Photo 10
Horizontal Crack on Roof of Varanda of Shop no.195, Ground Floor
Approx. Width = 1mm, Approx. Length = 2.5m. Distance from Rightside
External Column = 1.05m, Height from Floor = 3m.

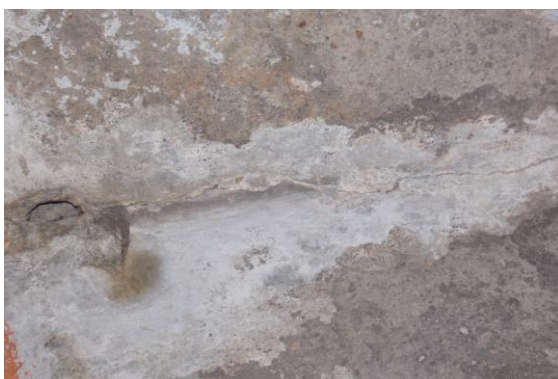
Photo 11
Horizontal Crack on Roof of Varanda of Shop No.195, Ground Floor
Approx. Width = 1mm, Approx. Length = 2.5m. Distance from Leftside
External Column = Backside, Height from Floor = 3m.

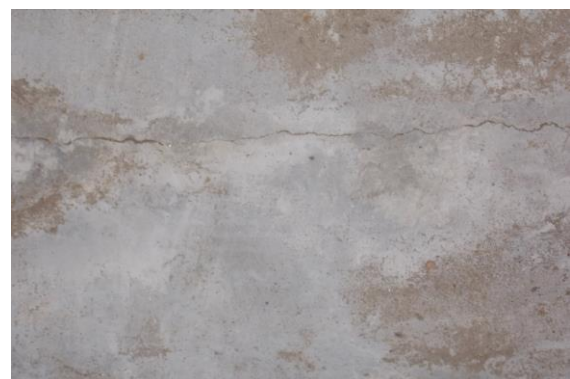
Photo 12
Horizontal Crack on Roof of Varanda of Shop No.195, Ground Floor
Approx. Width = 2mm, Approx. Length = 2.5m. Distance from Rightside
External Column = Backside, Height from Floor = 3m.

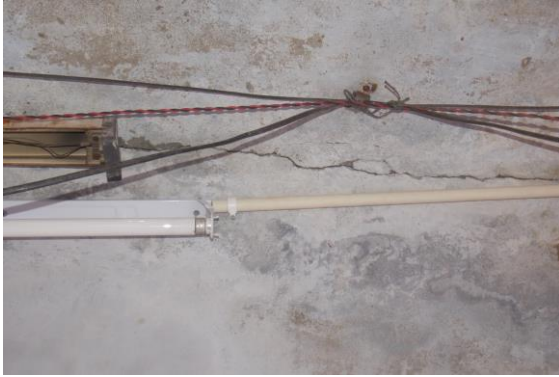
Photo 13

Horizontal Crack on Roof of Varanda of Shop No.195, Ground Floor
Approx. Width = 2mm, Approx. Length = 2.5m. Distance from Rightside
External Column = Backside, Height from Floor = 3m.

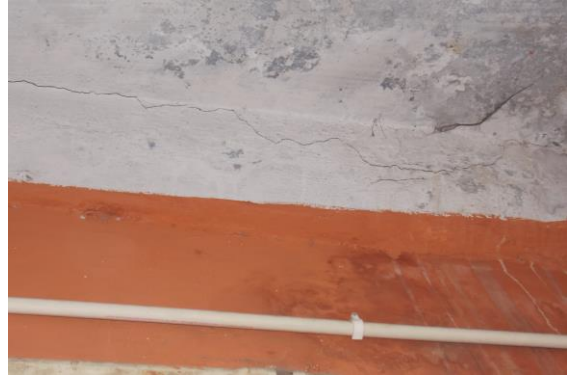
Photo 14

Horizontal Crack on Beam of Varanda of Shop No.197, Ground Floor
Approx. Width = 0.6mm, Approx. Length = 3.5m. Distance from Leftside
External Column = Backside, Height from Floor = 3m.

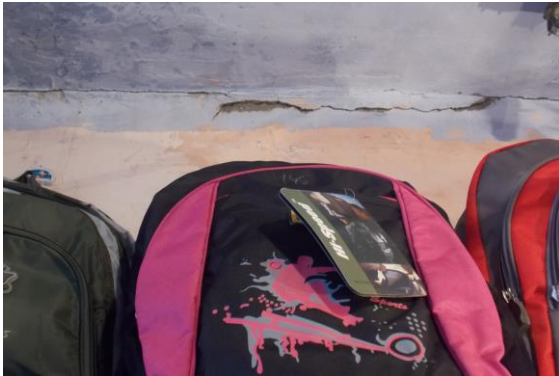
Photo 15

Peeling of Plaster on Beam Left Side of Varanda of Shop No.191 A of
Ground Floor

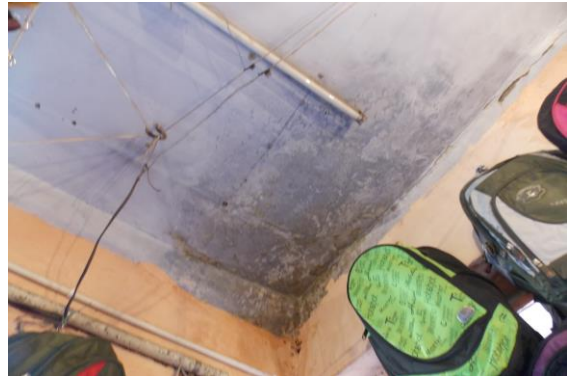
Photo 16

Dampness/Seepage on Roof of Varanda of Shop No.191 A of Ground
Floor

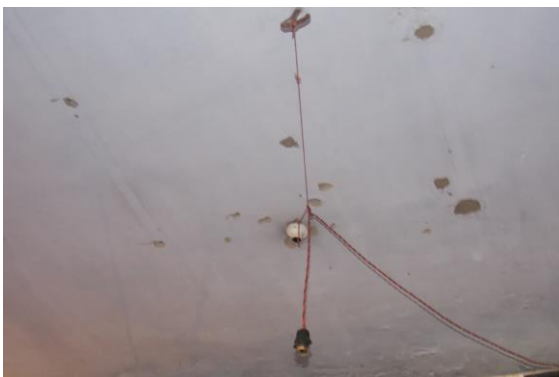
Photo 17

Peeling of Plaster on Roof of Varanda of Shop No.193 of Basement

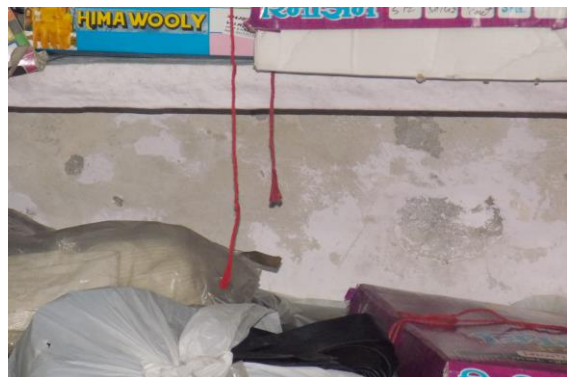
Photo 18

Dampness/Seepage on Wall No. 3 of Shop No.194 of Basement

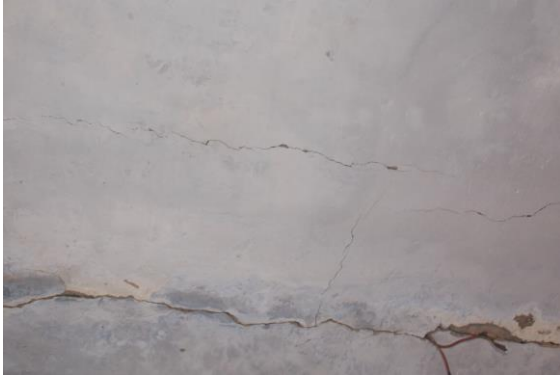
Photo 19
Damaged Portion on Roof of Varanda of Shop No.194 of Ground Floor

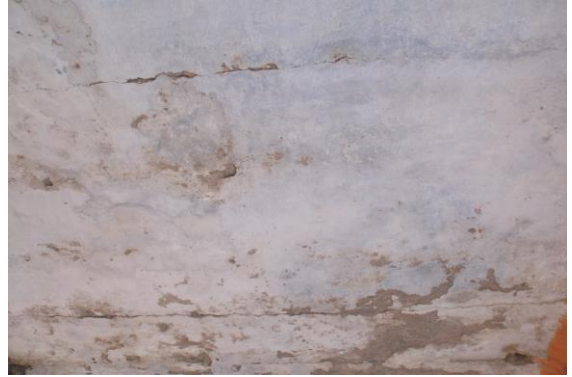
Photo 20
Dampness/Seepage on Roof of Varanda of Shop No.194 of Ground Floor

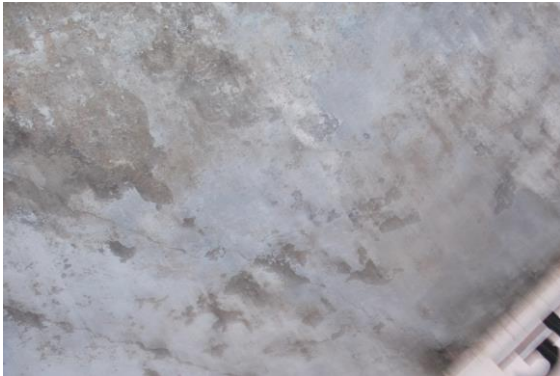
Photo 21
Peeling of Plaster on Roof of Varanda of Shop No.195 of Ground Floor

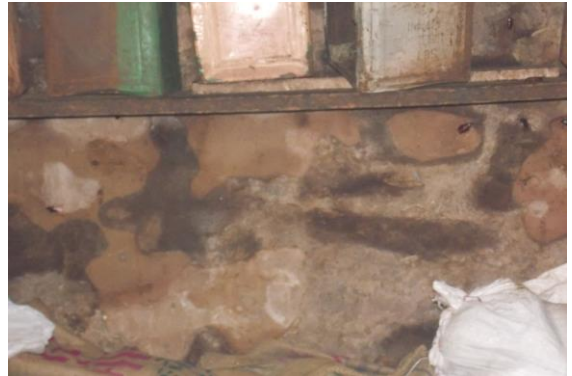
Photo 22
Damaged Portion on Wall No. 2 of Shop No.196 of Basement

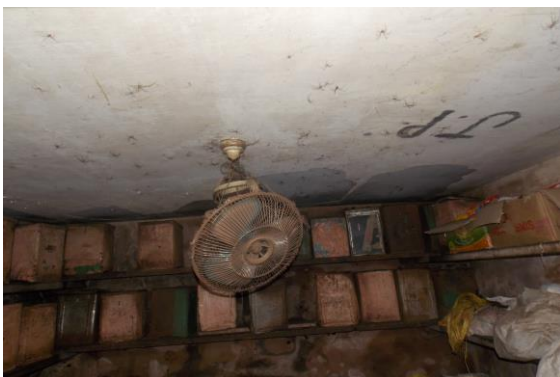
Photo 23
Peeling of Plaster on Roof of Shop No.196 of Basement

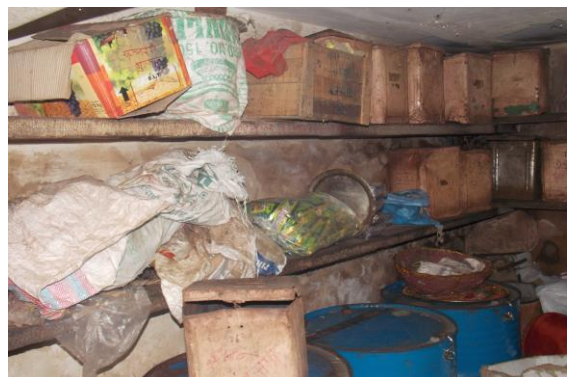
Photo 24
Damaged Portion on Wall No. 4 of Shop No.196 of Basement

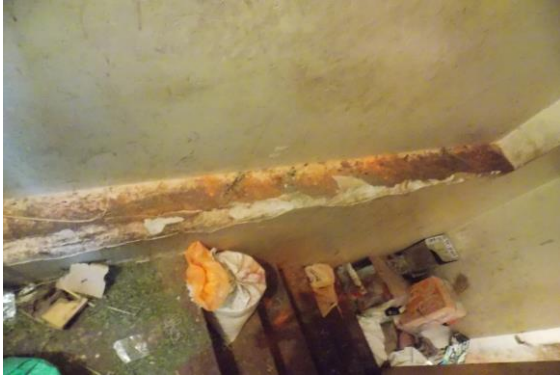
Photo 25
Peeling of Plaster on Wall No. 1 of Staircase of Basement

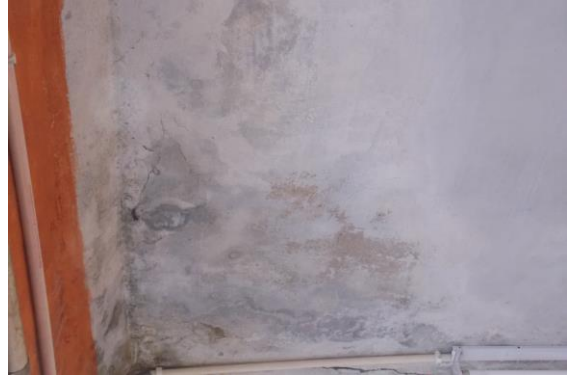
Photo 26
Dampness/Seepage on Roof of Varanda of Shop No.196 of Ground Floor

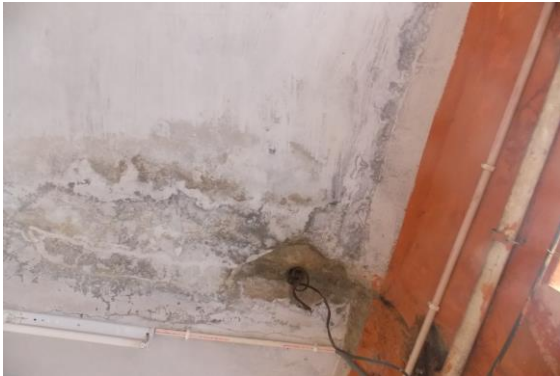
Photo 27
Damaged Portion on Roof of Varanda of Shop No.197 of Ground Floor

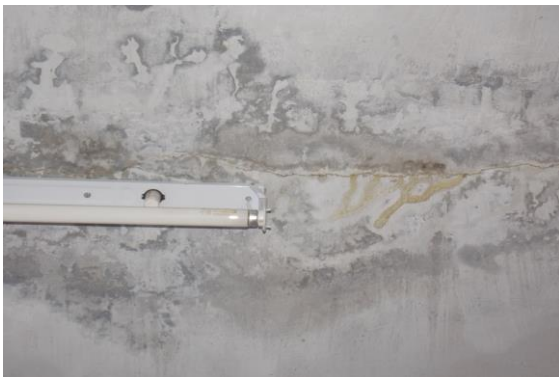
Wall No. 3 of Shop no.325 of Ground Floor Covered With Wooden Racks & Material

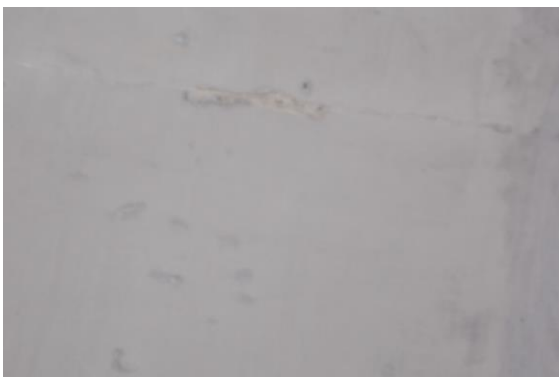
Pre - Condition Building Survey for Construction of Underground Stations from Chandpole to Bari Chouper and reversal line

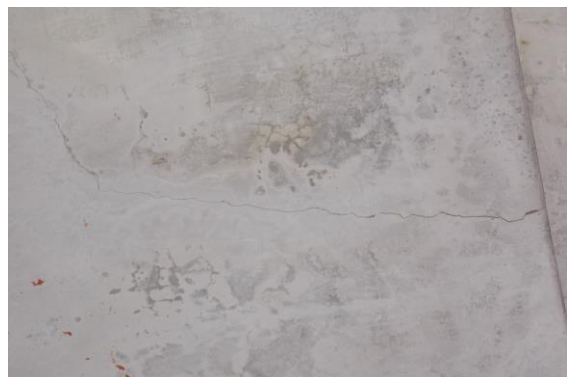
Photo 79

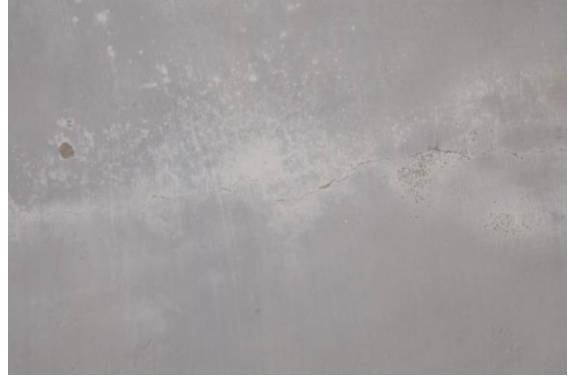
Photo 31

Inclined Crack on Roof of Varanda of Shop No.208, Ground Floor
Approx. Width = 1mm, Approx. Length = 2.8m. Distance from Rightside
External Column = Backsidem, Height from Floor = 3m.

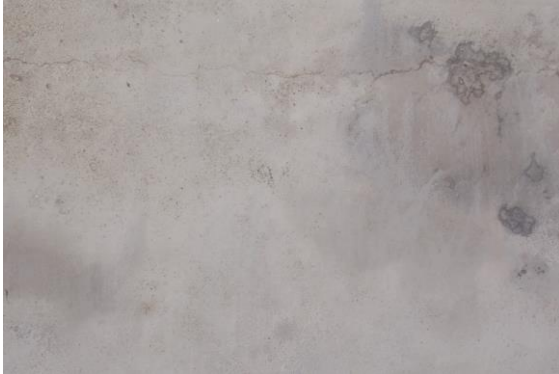
Photo 32

Horizontal Crack on Roof of Varanda of Shop No.208, Ground Floor
Approx. Width = 0.1mm, Approx. Length = 1.5m. Distance from Leftside
External Column = 1.4m, Height from Floor = 3m.

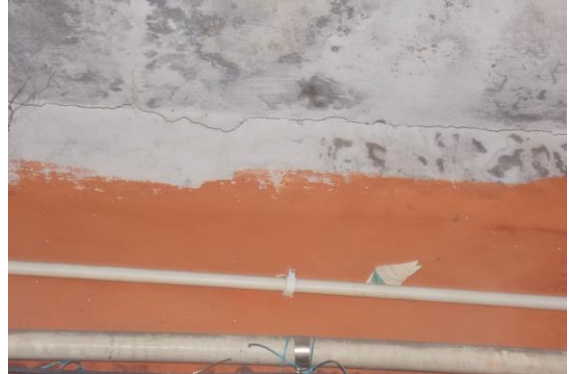
Photo 33

Horizontal Crack on Roof of Varanda of Shop No.209, Ground Floor
Approx. Width = 0.15mm, Approx. Length = 2.5m. Distance from
Leftside External column = 1.5m, Height from Floor = 3m.

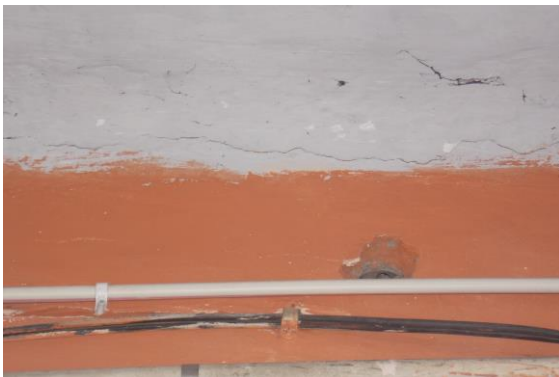
Photo 34

Horizontal Crack on Roof of Varanda of Shop No.209, Ground Floor
Approx. Width = 0.6mm, Approx. Length = 3m. Distance from Rightside
External Column = Backsidem, Height from Floor = 3m.

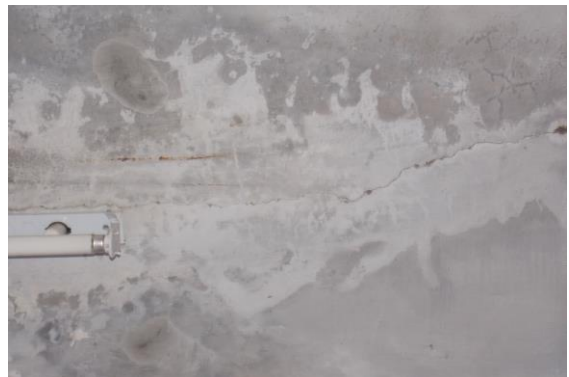
Photo 35

Horizontal Crack on Roof of Varanda of Shop No.212, G/F Approx.
Width = 1mm, Approx. Length = 3m. Distance from R/s External Column
=L/s Beamm, Height from Floor = 3m.

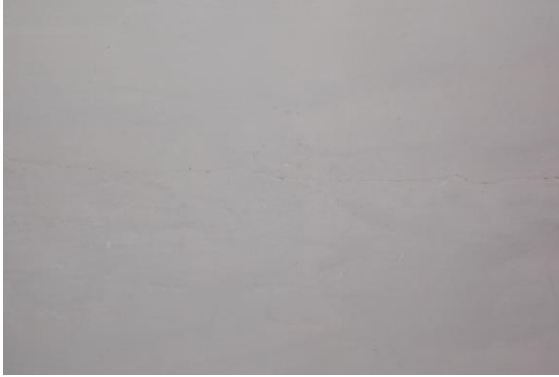
Photo 36

Horizontal Crack on Roof of Varanda of Shop No.213, Ground Floor
Approx. Width = 1mm, Approx. Length = 2.6m. Distance from Leftside
External column = Backsidem, Height from Floor = 3m.

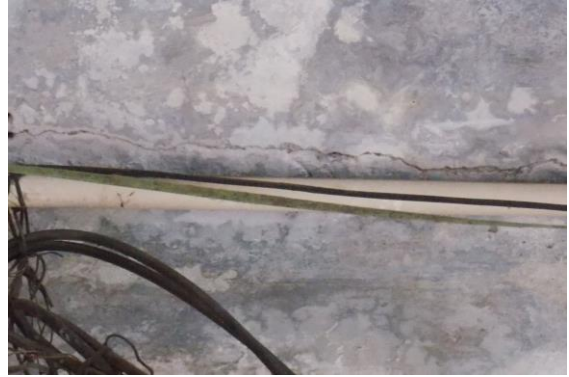
Photo 37

Horizontal Crack on Roof of Varanda of Shop No.213, Ground Floor
Approx. Width = 0.1mm, Approx. Length = 2.5m. Distance from Leftside
External column = 1.5m, Height from Floor = 3m.

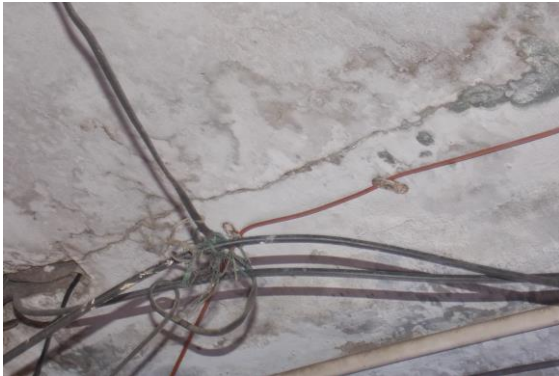
Photo 38

Horizontal Crack on Roof of Varanda of Shop No.213, G/F Approx.
Width = 0.25mm, Approx. Length = 2.5m. Distance from Rightside
External Column = Backside, Height from Floor = 3m.

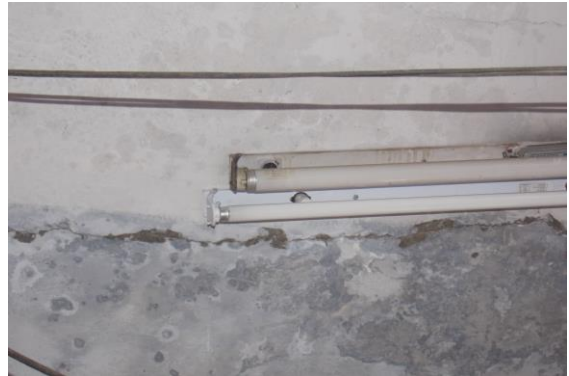
Photo 39

Horizontal Crack on Roof of Varanda of Shop No.214, Ground Floor
Approx. Width = 1mm, Approx. Length = 1.9m. Distance from Leftside
External column = 0m, Height from Floor = 3m.

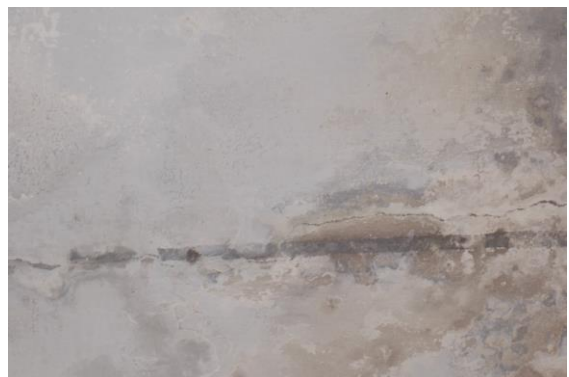
Photo 40A

Horizontal Crack on Roof of Varanda of Shop No.214, G/F, Approx.
Width = 1.5mm, Approx. Length = 3.1m. Distance from Leftside External
column = Backside, Height from Floor = 3m.

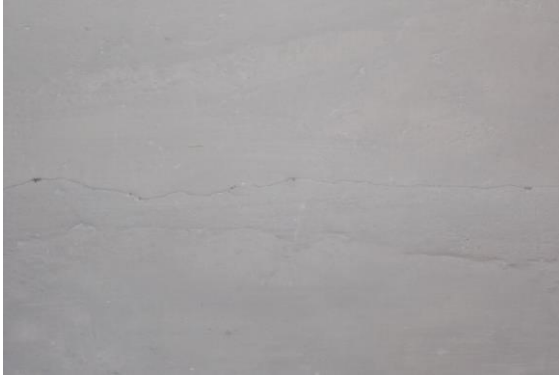
Photo 41

Horizontal Crack on of Varanda of Shop No.217, Ground Floor Approx.
Width = 0.15mm, Approx. Length = 2.5m. Distance from Rightside
External Column = 1.5m, Height from Floor = 3m.

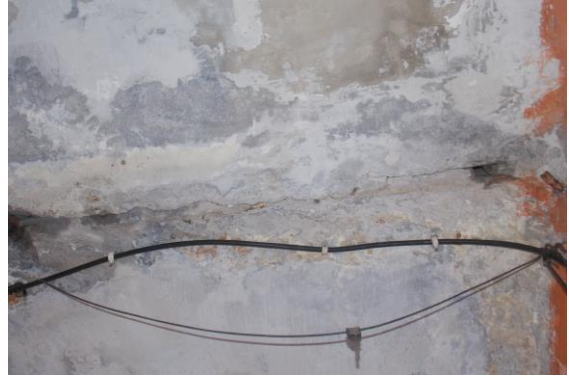
Photo 42

Horizontal Crack on Roof of Varanda of Shop No.218, Ground Floor
Approx. Width = 0.35mm, Approx. Length = 2.5m. Distance from
Rightside External Column = 0m, Height from Floor = 3m.

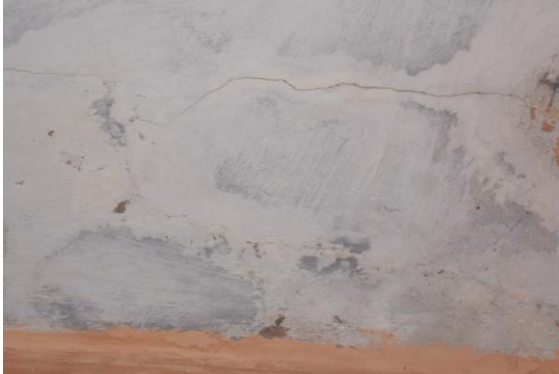
Photo 43

Horizontal Crack on Roof of Varanda of Shop No.219, Ground Floor
Approx. Width = 1mm, Approx. Length = 2.5m. Distance from Rightside
External Column = Backsidem, Height from Floor = 3m.

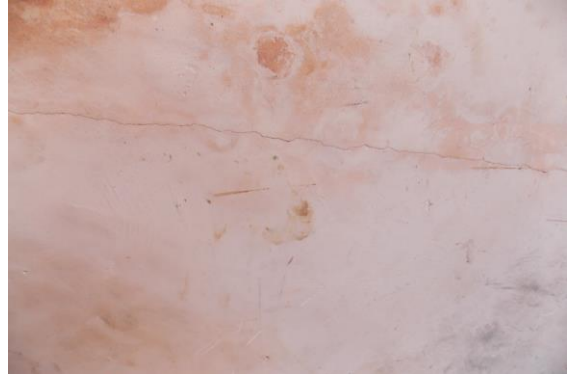
Photo 44

Horizontal Crack on Roof of Varanda of Shop No.220, Ground Floor
Approx. Width = 0.4mm, Approx. Length = 1m. Distance from Rightside
External Column = Backsidem, Height from Floor = 3m.

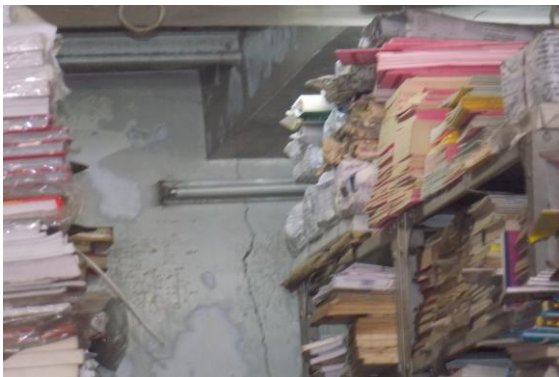
Photo 45

Inclined Crack on Rightside Wall of Varanda of Shop No.220, G/F
Approx. Width = 0.25mm, Approx. Length = 4m. Distance from
Rightside External Column = 0.2m, Height from Floor = 0m.

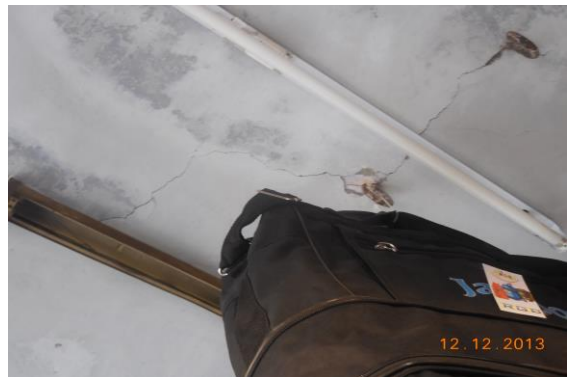
Photo 46

Inclined Crack on Wall No. 4 of Part B of Shop No.220, Ground Floor
Approx. Width = 1.5mm, Approx. Length = 1.5m. Distance from Wall
No.2 = 1.5m, Height from Floor = 1.5m.

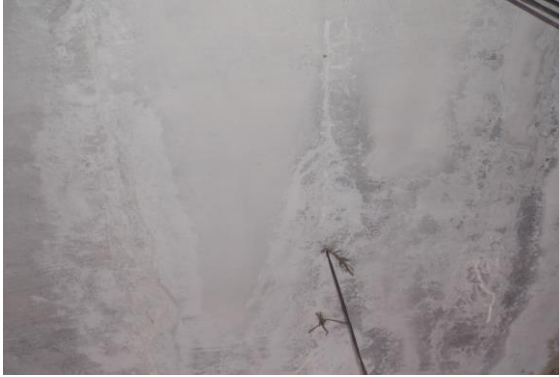
Photo 47

Horizontal Crack on Roof of Varanda of Purohit Ji ka Katla (Shetty
Complex), Ground Floor Approx. Width = 0.8mm, Approx. Length =
2.3m. Distance from left side column = 0m, Height from Floor = 3m.

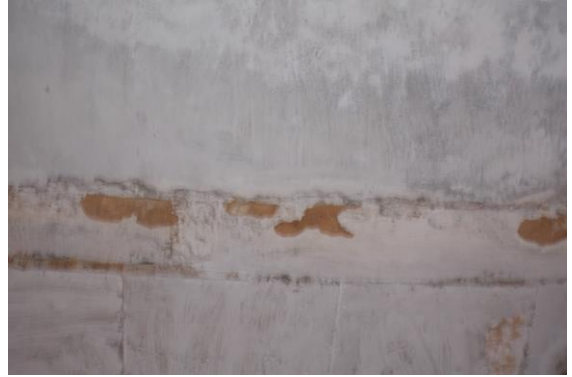
Photo 48

Dampness/Seepage on Roof of Varanda of Shop No.201 of Ground Floor

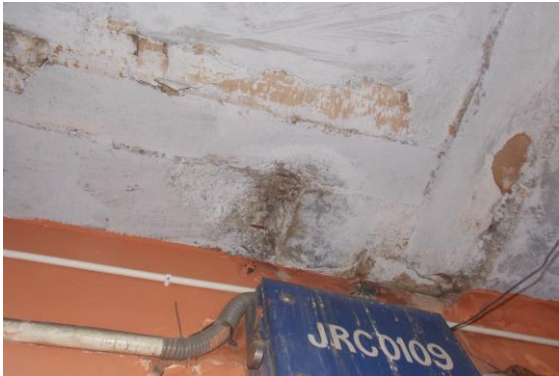
Photo 49

Peeling of Plaster on Roof of Varanda of Shop No.201 of Ground Floor

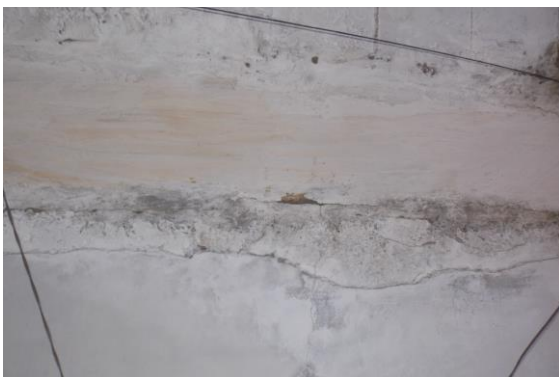
Photo 51

Peeling of Plaster on Roof of Varanda of Shop No.203 of Ground Floor

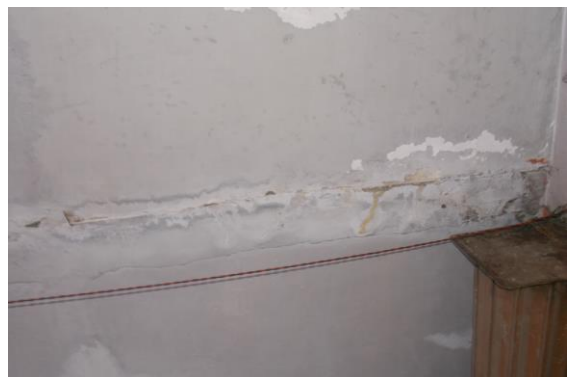
Photo 52

Peeling of Plaster on Roof of Varanda of Shop No.204 of Ground Floor

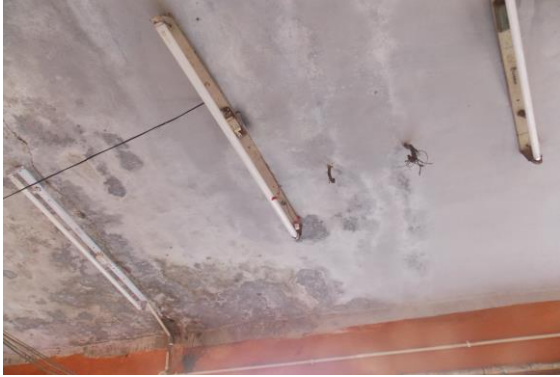
Photo 54

Dampness/Seepage on Roof of Varanda of Shop No.208 of Ground Floor

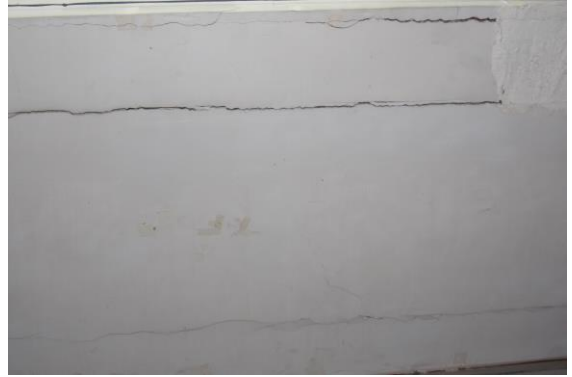
Photo 55

Peeling of Plaster on Roof & Beam of Varanda of Shop No.209 of Ground Floor

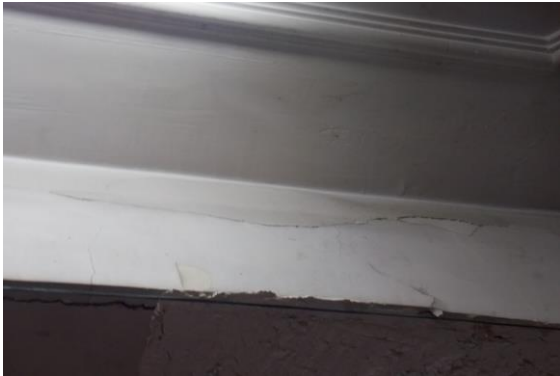
Photo 56

Peeling of Plaster on Roof & Beam of Varanda of Shop No.209 of Ground Floor

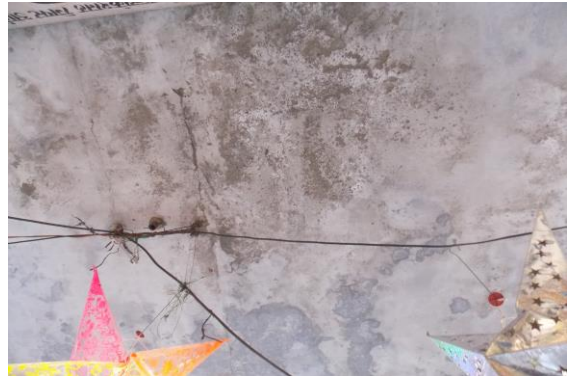
Photo 57

Dampness/Seepage on Roof of Varanda of Shop No.209 of Ground Floor

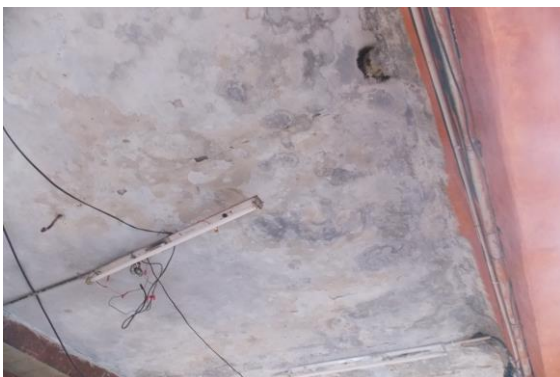
Photo 58

Dampness/Seepage on Roof of Shop No.210 of Ground Floor

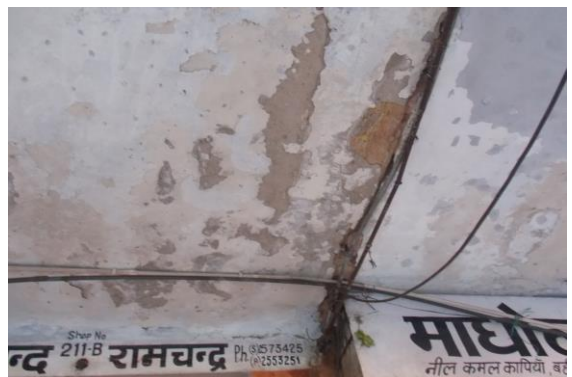
Photo 59

Damaged Portion on Roof of Varanda of Shop No.211 B of Ground Floor

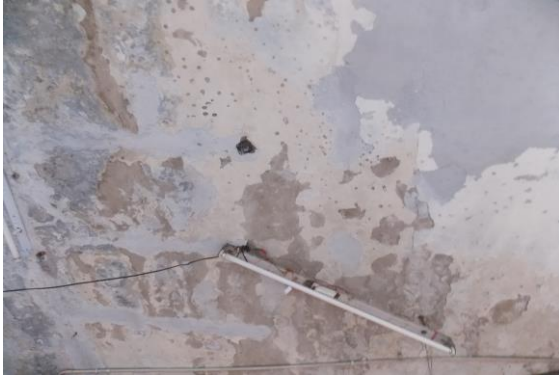
Photo 60

Dampness/Seepage on Roof of Varanda of Shop No.211A of Ground Floor

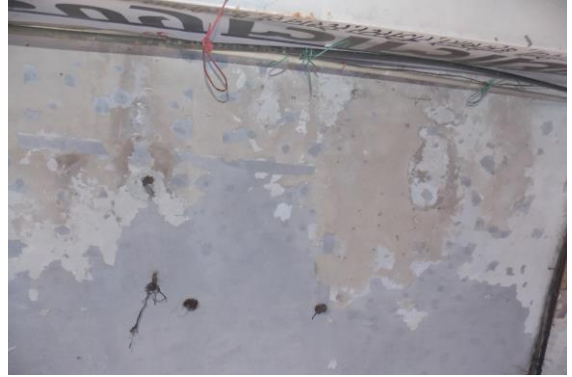
Photo 61

Peeling of Plaster on Roof of Varanda of Shop No.212 of Ground Floor

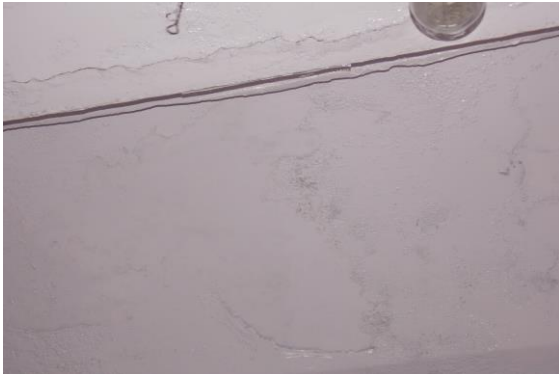
Photo 62

Peeling of Plaster on Roof of Shop No.213 of Ground Floor

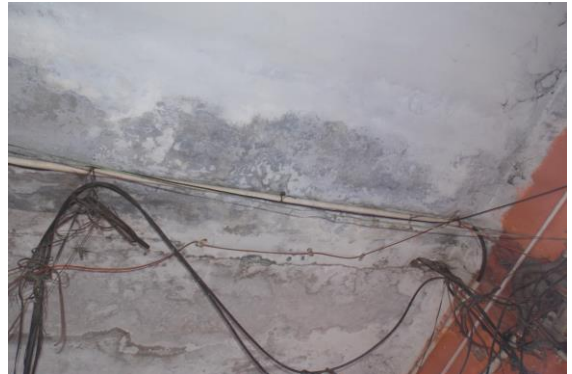
Photo 63

Dampness/Seepage on Roof of Varanda of Shop No.213 of Ground Floor

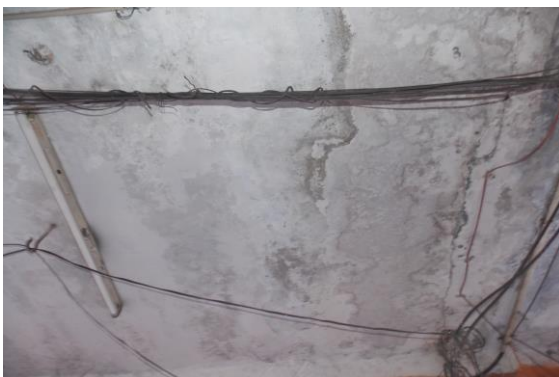
Photo 64

Dampness/Seepage on Roof of Varanda of Shop No.214 of Ground Floor

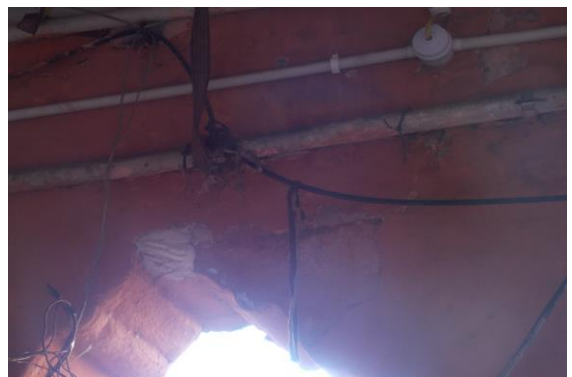
Photo 65

Peeling of Plaster on Rightside External Column of Varanda of Shop No.214 of Ground Floor

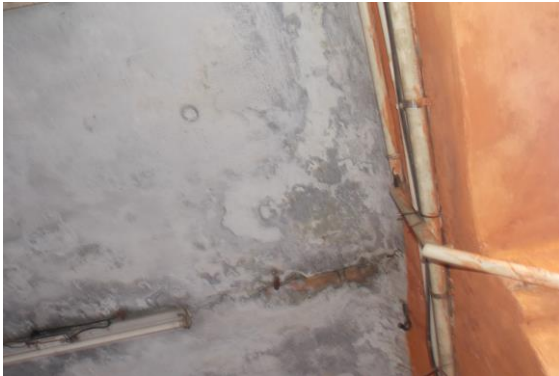
Photo 66

Dampness/Seepage on Roof of Varanda of Shop No.215 of Ground Floor

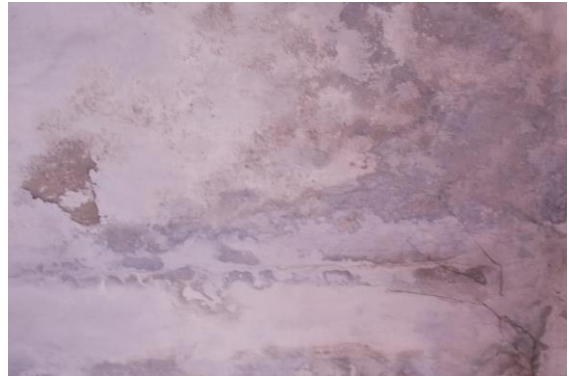
Photo 67

Dampness/Seepage on Roof of Varanda of Shop No.216 of Ground Floor

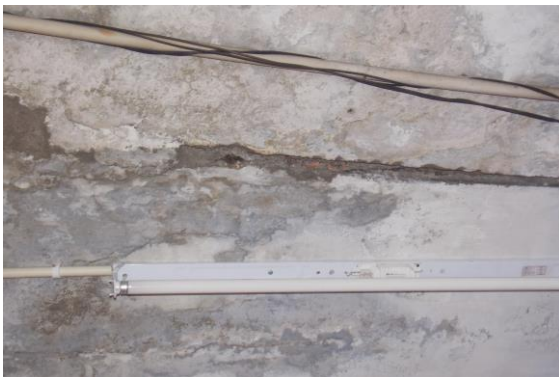
Photo 68

Damaged Portion on Roof of Varanda of Shop No.217 of Ground Floor

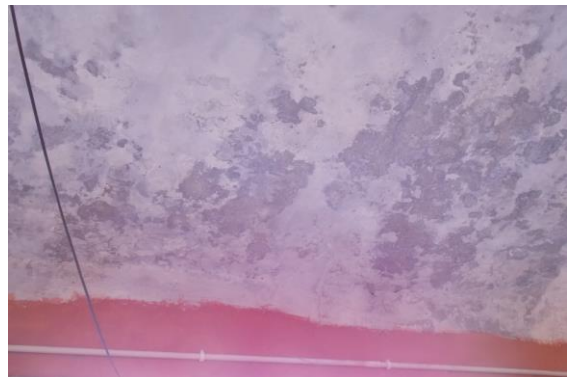
Photo 69

Dampness/Seepage on Roof of Varanda of Shop No.218 of Ground Floor

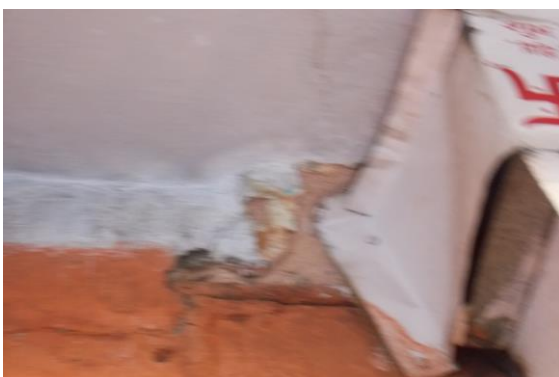
Photo 70

Peeling of Plaster on Leftside Wall of Varanda of Shop No.218 of Ground Floor

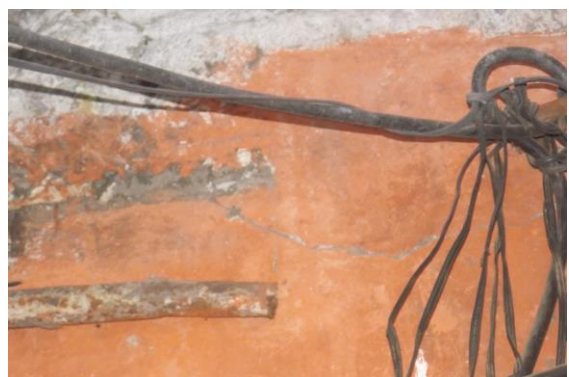
Photo 71

Damaged Portion on Rightside Wall of Varanda of Shop No.218 of Ground Floor

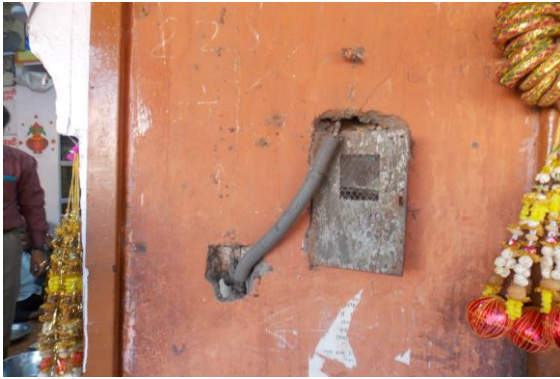
Photo 72

Damaged Portion on Rightside Wall of Varanda of Shop No.218 of Ground Floor

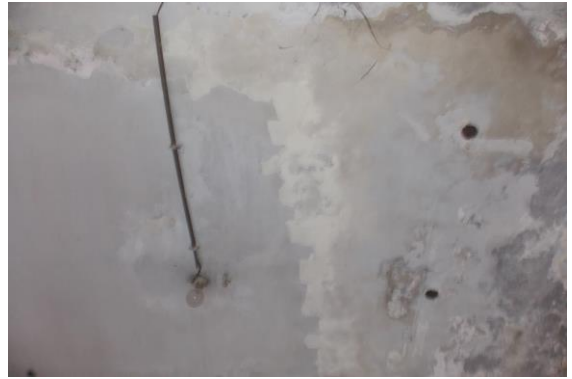
Photo 73

Peeling of Plaster on Roof of Varanda of Shop No.219 of Ground Floor

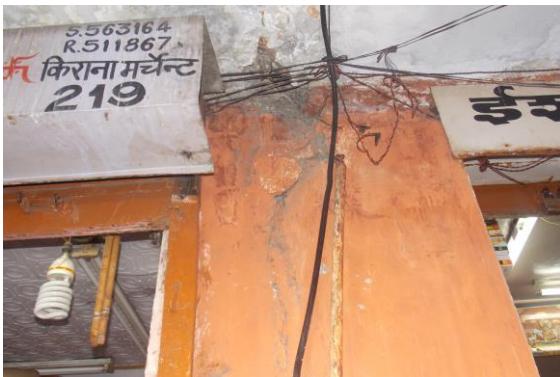
Photo 74

Damaged Portion on Rightside External Beam of Varanda of Shop No.219 of Ground Floor

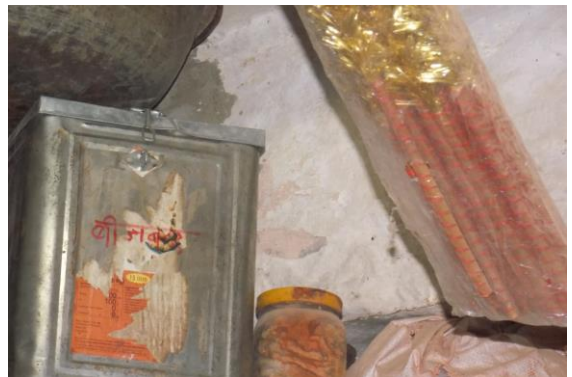
Photo 75

Peeling of Plaster on Wall No. 4 of Part B of Shop No.219 of Ground Floor

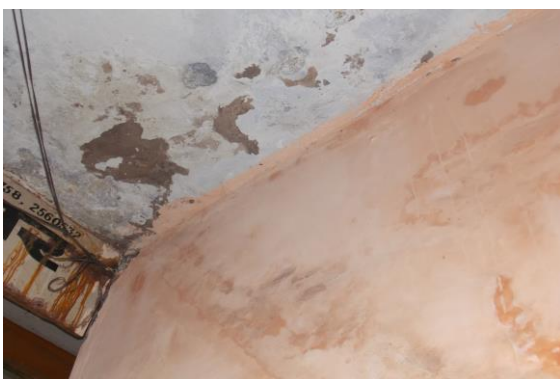
Photo 76

Dampness/Seepage on Roof & RightSide Wall of Varanda of Shop No.220 of Ground Floor

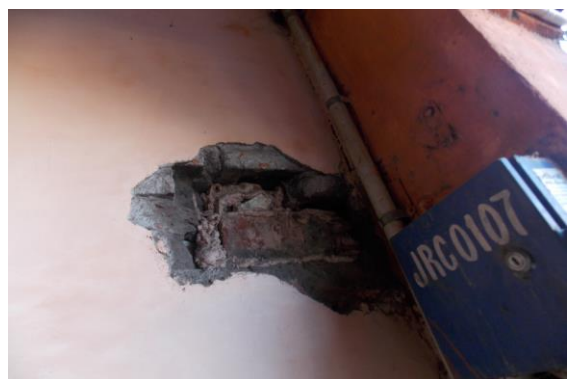
Photo 77

Damaged Portion on Rightside wall of Varanda of Shop No.220 of Ground Floor

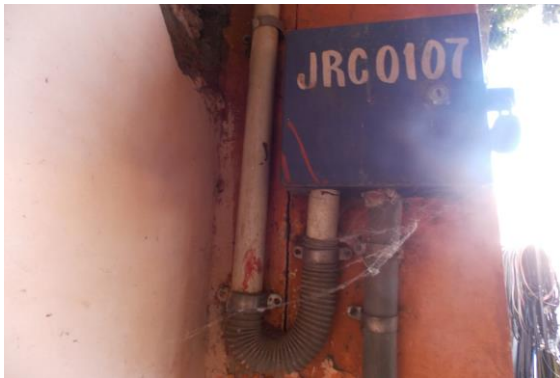
Photo 78

Damaged Portion on Rightside external Beam of Varanda of Shop No.220 of Ground Floor

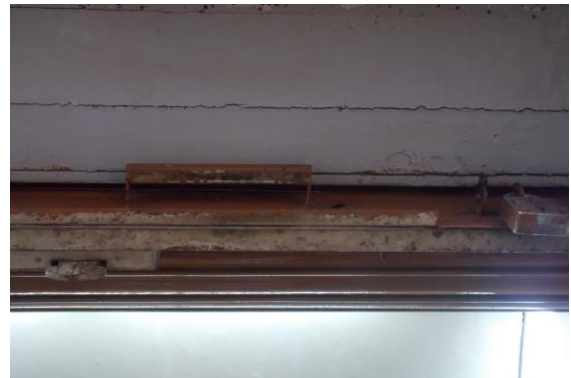
Photo 79

Plaster Crack on Roof & Beam of Part A of Shop No.220 of

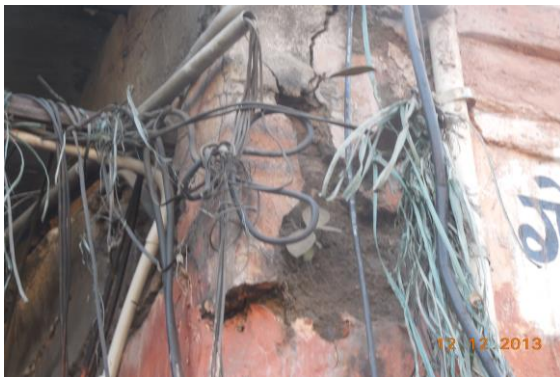
Photo 80

Peeling of Plaster on of Shop No. 200 of Purohit Ji ka Katla (Shetty Complex) of Ground Floor

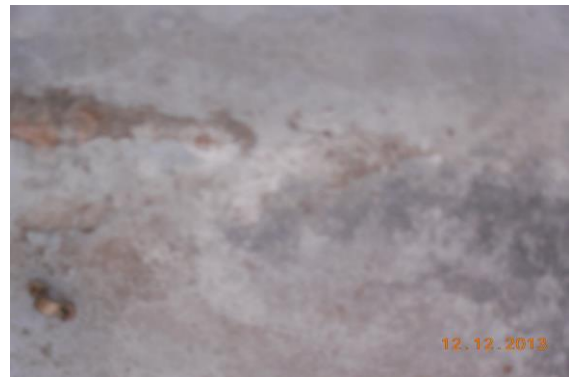
Photo 81

Dampness/Seepage on Roof of Varanda of Purohit Ji ka Katla (Shetty Complex) of Ground Floor

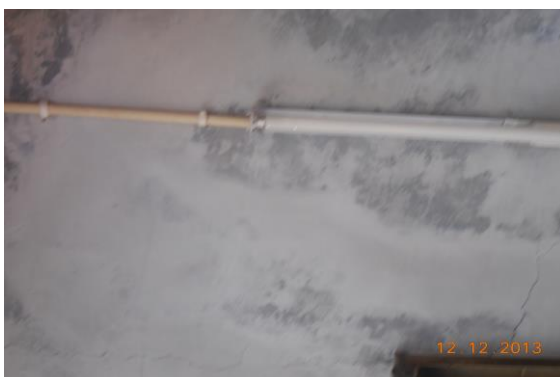
Photo 82

Dampness/Seepage on Roof of Varanda of Purohit Ji ka Katla (Shetty Complex) of Ground Floor

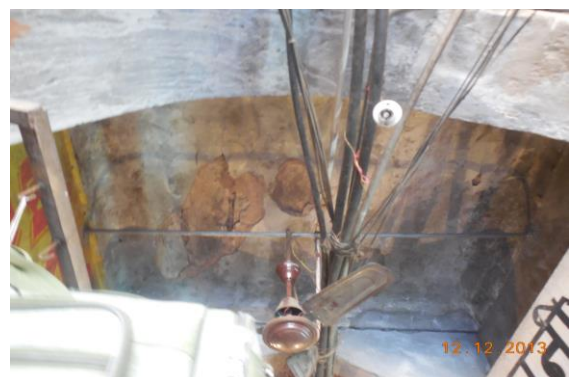
Photo 83

Peeling of Plaster on of Passage Between Shop No.199 & 200 of Purohit Ji ka Katla (Shetty Complex) of Ground Floor

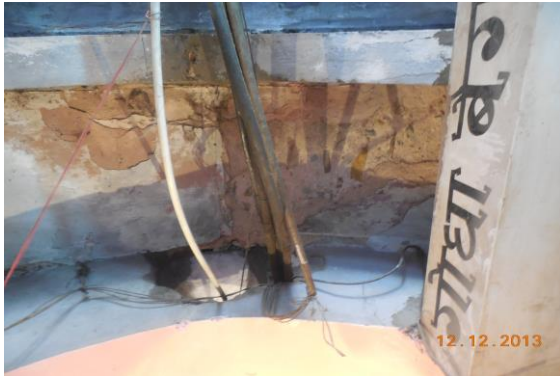
Photo 84

Peeling of Plaster on of Passage Between Shop No.199 & 200 of Purohit Ji ka Katla (Shetty Complex) of Ground Floor

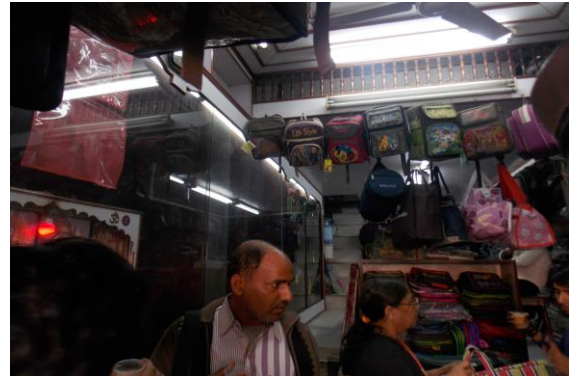
Photo 85

Wall No. 1 of Shop No.198 of Ground Floor Covered With Material

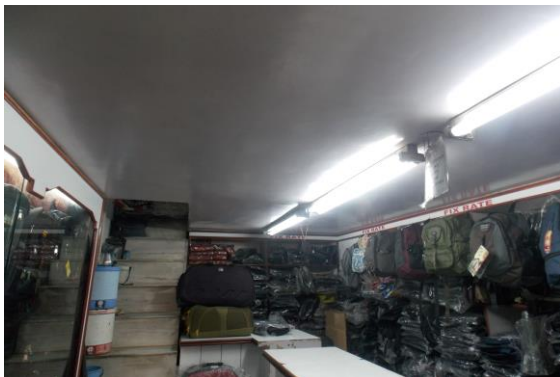
Photo 86

Wall No. 4 of Shop No.198 of Ground Floor Covered With Material

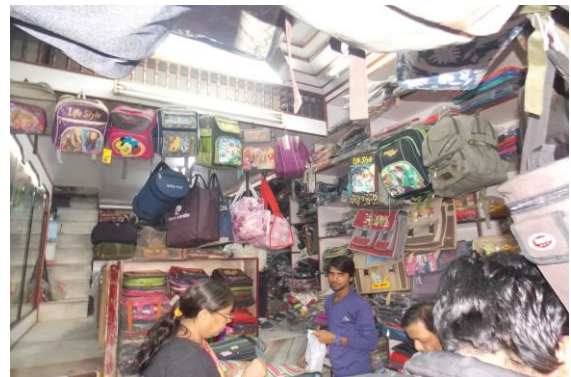
Photo 87

Wall No. 2 of Shop No.198 of Ground Floor Covered With Material

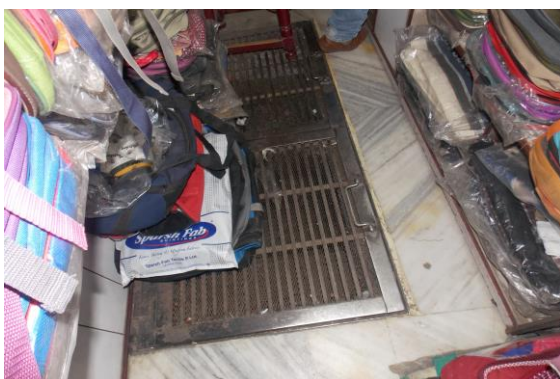
Photo 88

Shop No.198 of Basement Locked No Way to Basement

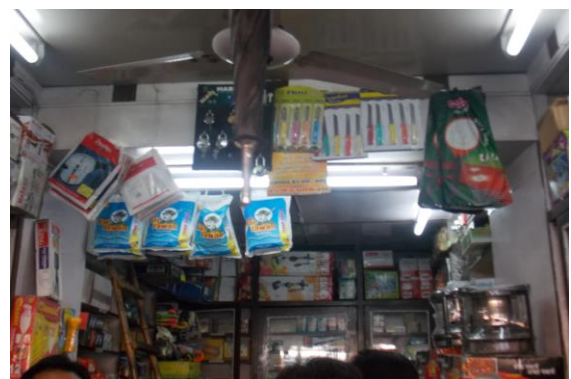
Photo 89

All Walls of Shop No.201 of Ground Floor Covered With Material & Wooden Racks

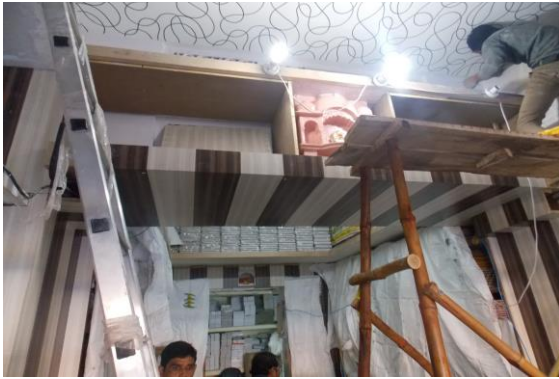
Photo 90

All Walls of Shop No.202 of Ground Floor Under Renovation

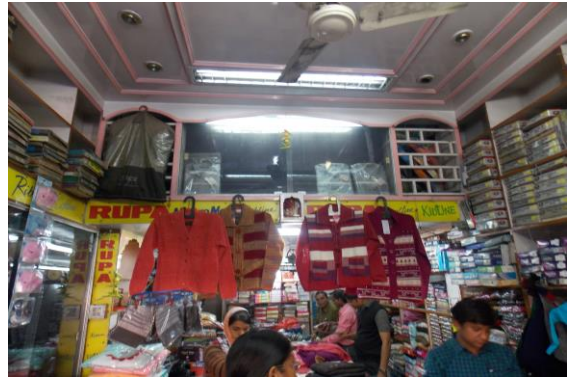
Photo 91

All Walls of Shop No.203 of Ground Floor Covered With Material

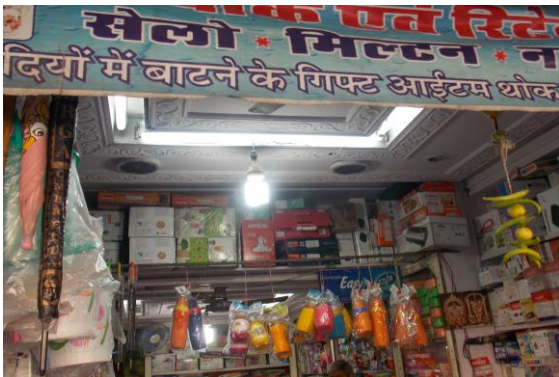
Photo 92

All Walls of Shop No.204 of Ground Floor Covered With Material

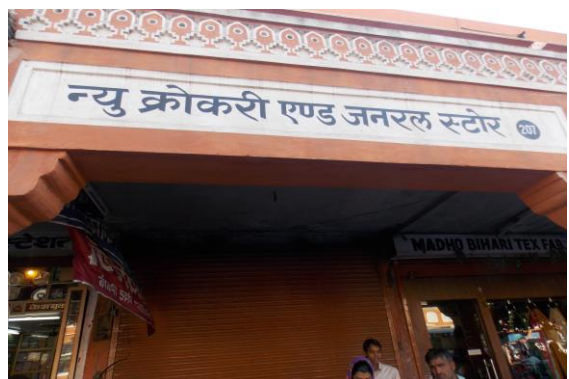
Photo 94

All Walls of Shop No.206 of Ground Floor Covered With Wooden Racks & Material

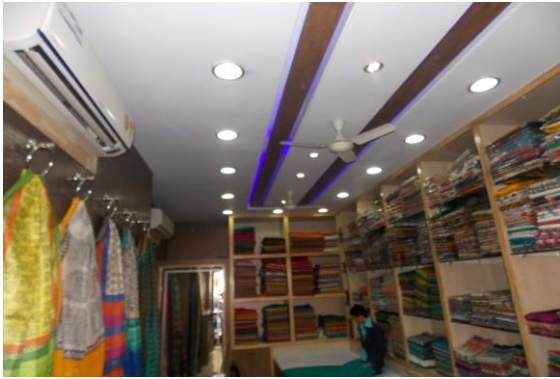
Photo 95

Shop No.207 of Ground Floor Locked

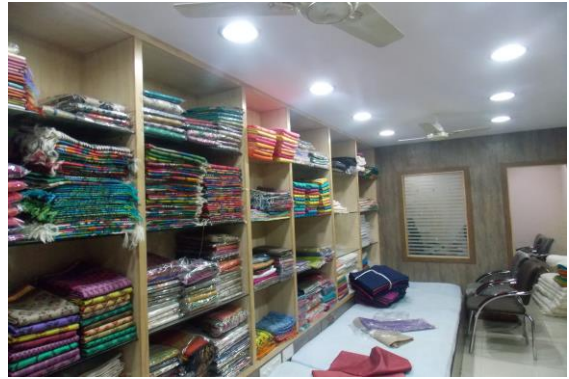
Photo 96

All Walls of Shop No.208 of Ground Floor Covered With Material & wooden Works

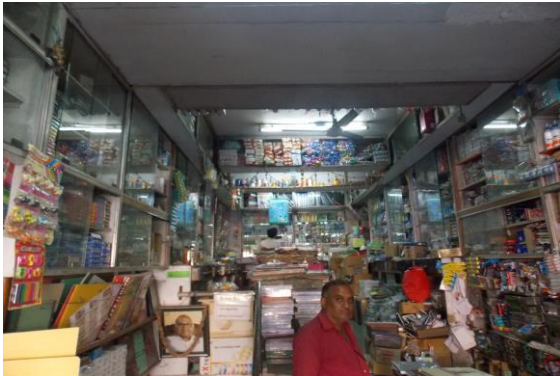
Photo 97

Wall No. 4 of Shop No.208 of Basement Covered With Material & wooden Works

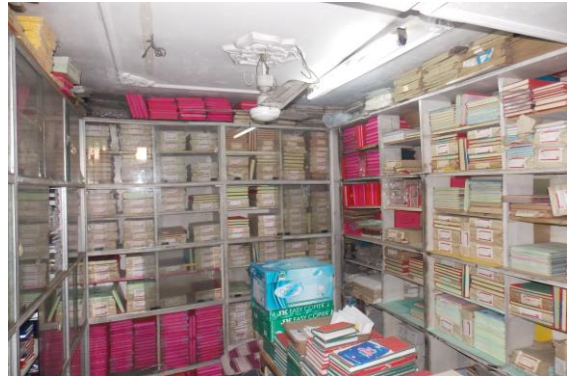
Photo 98

All Walls of Shop No.209 of Ground Floor Covered With Material

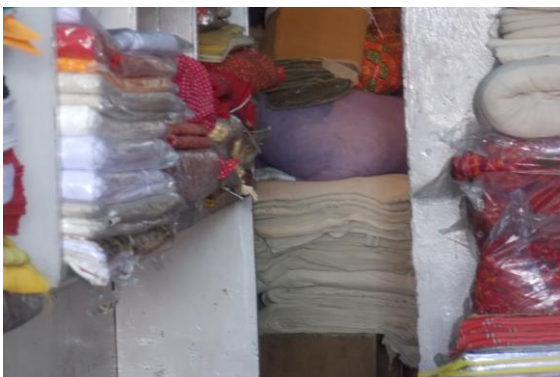
Photo 99

All Walls of Shop No.209 of Basement Covered With Material

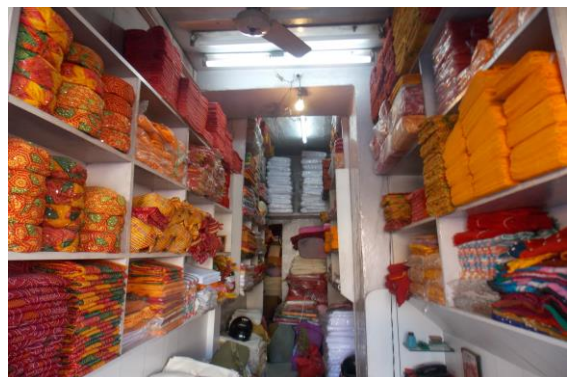
Photo 100

All Walls of Part B of Shop No.211 B of Ground Floor Covered With Material

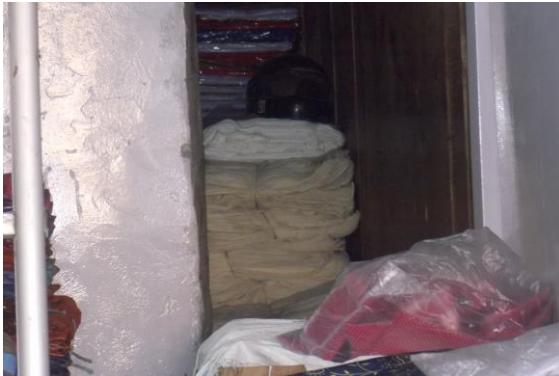
Photo 101

All Walls of Part A of Shop No.211 B of Ground Floor Covered With Material
