Pre Building Condition Survey Report

Name and Address of Structure :	Choti Chopar to Badi Chopar (Down Line)
---------------------------------	---

Name of the Project	Contract JMRC-UG1B “Design and Construction of Tunnel between Chandpole and Badi Chouper and reverse line by Shield TBM, Underground Metro Stations at Choti Chouper and Badi Chouper by Cut and Cover Methods on East West Corridor of Jaipur Metro Rail Corporation Limited .”	
Owner :

Pre Building Condition Survey Report Choti Chopar to Badi Chopar (Down Line)

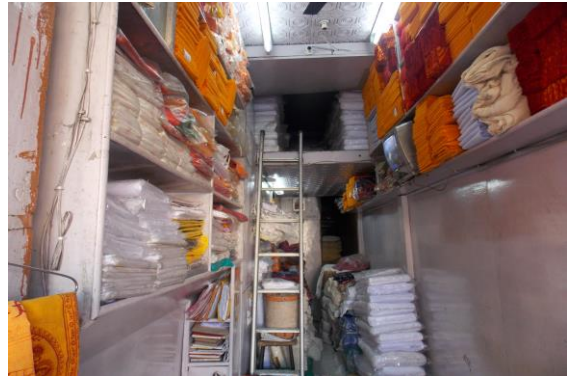
Photo 102
Shop No.211 A of Ground Floor No Way

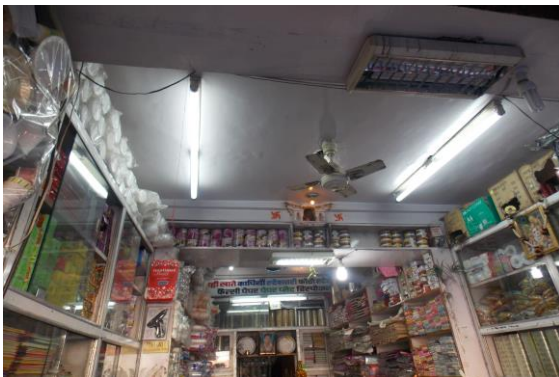
Photo 103
Part A of Shop No.211 A of Ground Floor

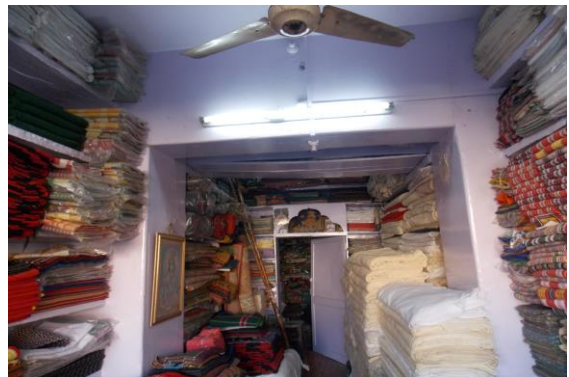
Photo 104
All Walls of Shop No.212 of Ground Floor Covered With Wooden Work

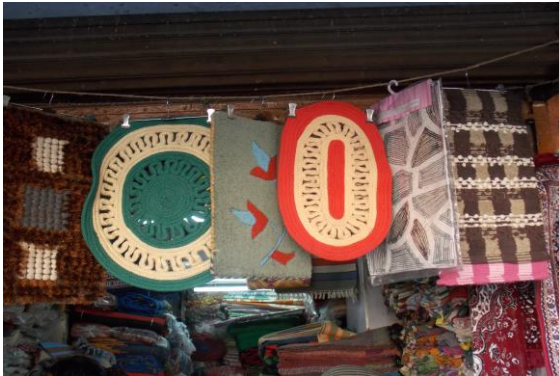
Photo 107
All Walls of Shop No.215 of Ground Floor Covered With Material & Wooden Works

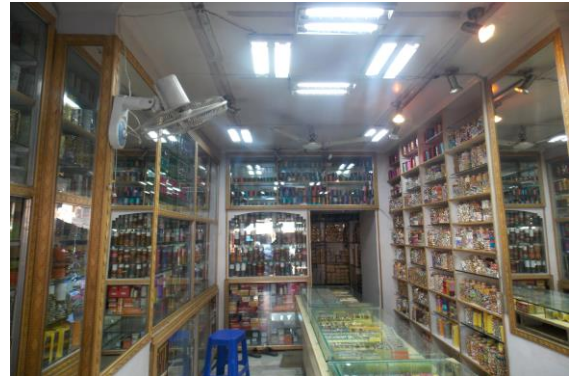
Photo 108

All Walls of Shop No.216 of Ground Floor Covered With Material & Wooden Works

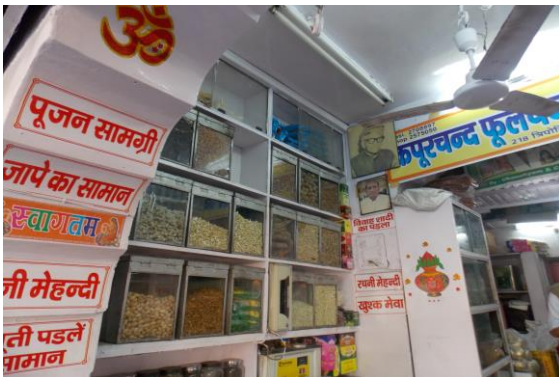
Photo 109

All Walls of Shop No.217 of Ground Floor Covered With Material

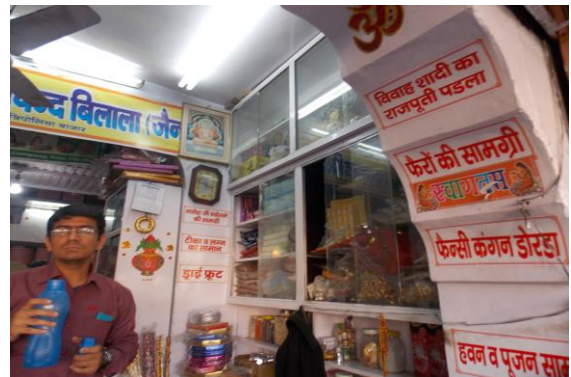
Photo 110

Wall No. 1 of Part A of Shop No.218 of Ground Floor Covered With Wooden Work

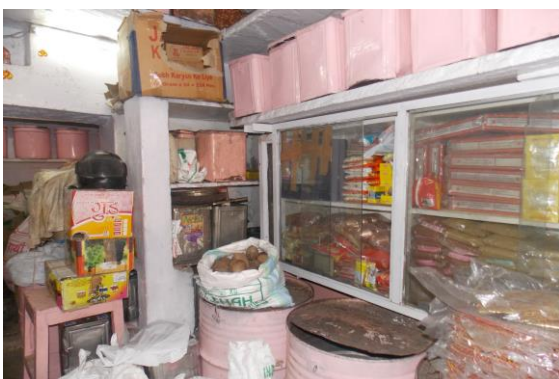
Photo 111

Wall No. 2 of Part A of Shop No.218 of Ground Floor Covered With Wooden Work

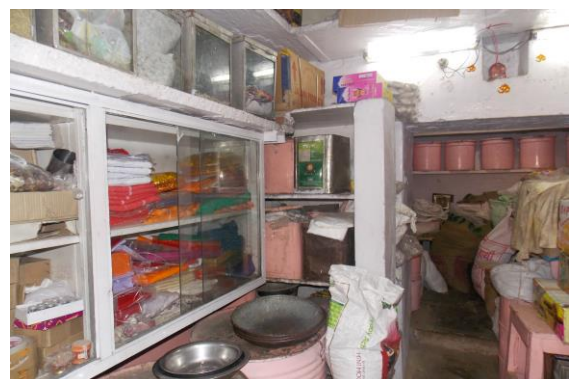
Photo 112

Wall No. 2 of Part B of Shop No.218 of Ground Floor Covered With Wooden Work

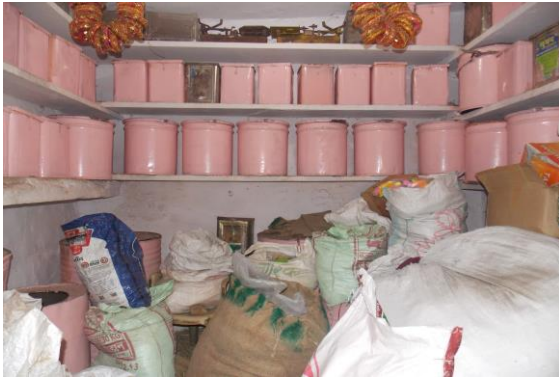
Photo 113

Wall No. 1 of Part B of Shop No.218 of Ground Floor Covered With Wooden Work

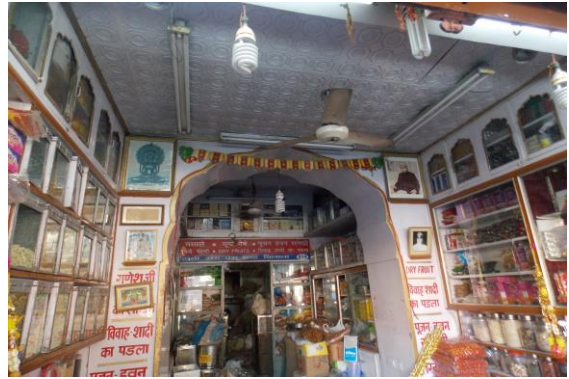
Photo 114

All Walls of Part C of Shop No. 218 of Ground Floor Covered With Wooden Work

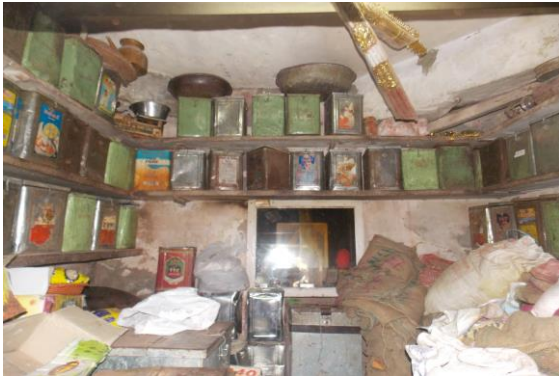
Photo 115

All Walls of Part A of Shop No. 219 of Ground Floor Covered With Material

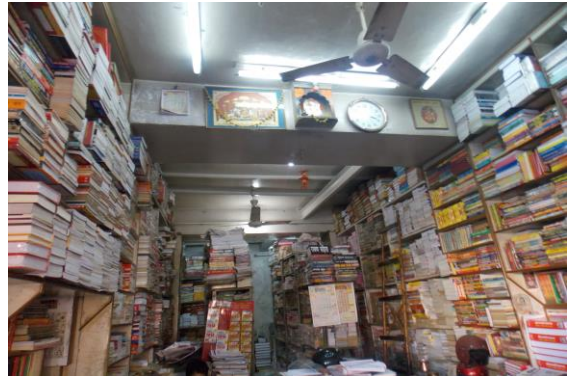
Photo 116

All Walls of Shop No. 219 of Ground Floor Covered With Material

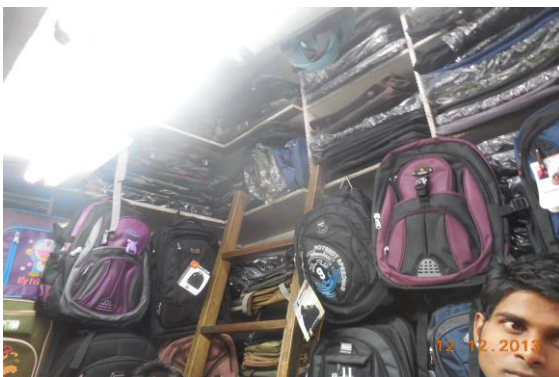
Photo 117

Part A+B of Shop no. 220 of Ground Floor Covered with wooden Racks & Material

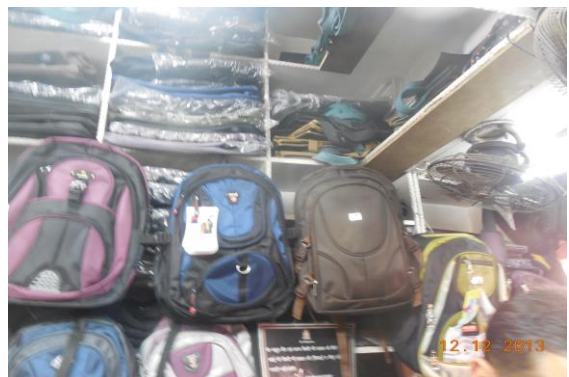
Photo 118

All Wall of Shop No. 200 of Purohit Ji ka Katla (Shetty Complex) of Ground Floor Covered With Material

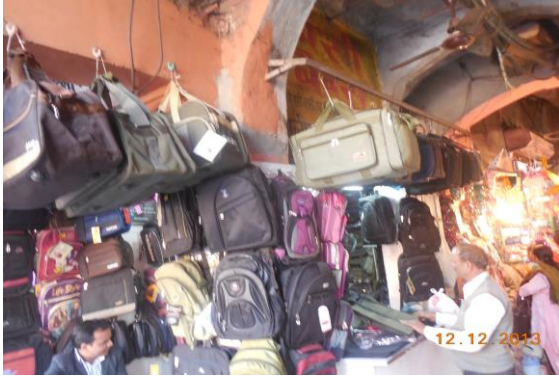
Photo 119

All Wall of Shop No. 200 of Purohit Ji ka Katla (Shetty Complex) of Ground Floor Covered With Material

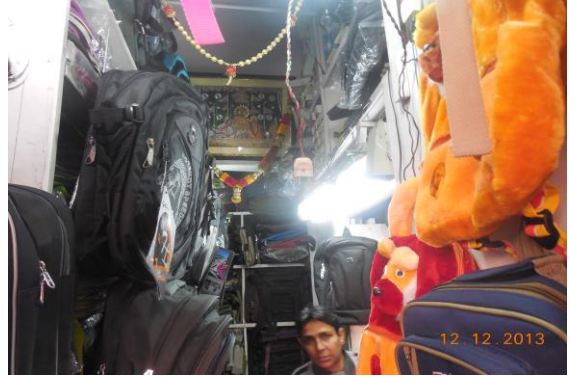
Photo 120

All Wall of Shop No. 199 of Purohit Ji ka Katla (Shetty Complex) of Ground Floor Covered With Material

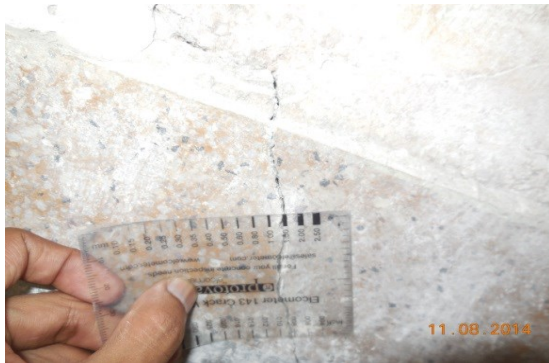
Photo 6B

Inclined Crack on Wall No.2 of Passage of Hind Hotel, Ground floor, Approx. Width=1.5mm, Approx.Length=2.5m. Distance from Wall No.4=2.2m, Height from Floor=1.0m.

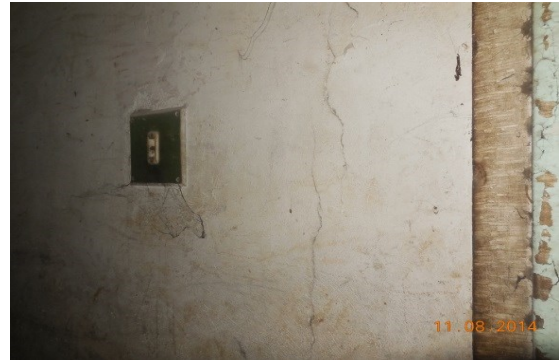
Photo 7A

Inclined Crack on Wall No.2 of Passage of Hind Hotel, First floor, Approx. Width=1.0mm, Approx.Length=1.8m. Distance from Wall No.3=0.25m, Height from Floor=0.0m.

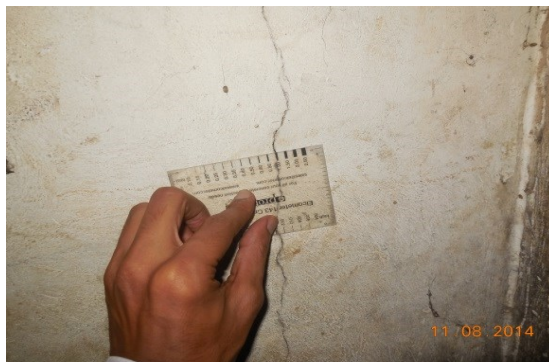
Photo 7B

Inclined Crack on Wall No.2 of Passage of Hind Hotel, First floor, Approx. Width=1.0mm, Approx.Length=1.8m. Distance from Wall No.3=0.25m, Height from Floor=0.0m.

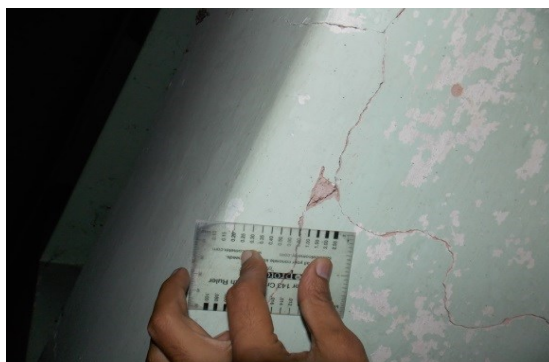
Photo 8B

Inclined Crack on Wall No.3 of Room No. 7 of Hind Hotel, First floor, Approx. Width=0.8mm, Approx.Length=1.0m. Distance from Wall No.2=1.3m, Height from Floor=1.8m.

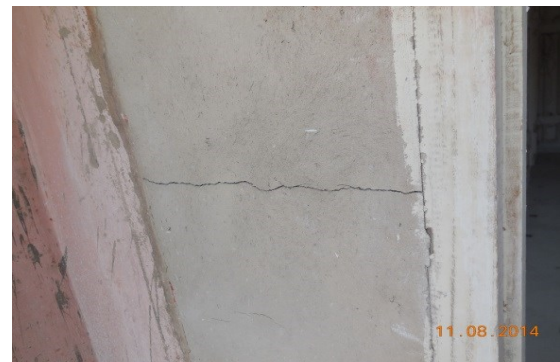
Photo 9A

Horizontal Crack on Wall No.3 of Balcony of Hind Hotel, Second floor, Approx. Width=1.5mm, Approx.Length=0.25m. Distance from Wall No.2=0.15m, Height from Floor=1.3m.

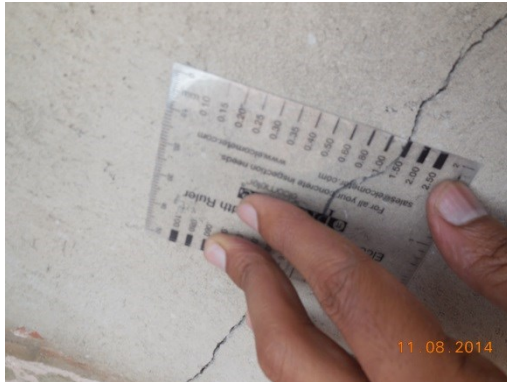
Photo 9B

Horizontal Crack on Wall No.3 of Balcony of Hind Hotel, Second floor, Approx. Width=1.5mm, Approx.Length=0.25m. Distance from Wall No.2=0.15m, Height from Floor=1.3m.

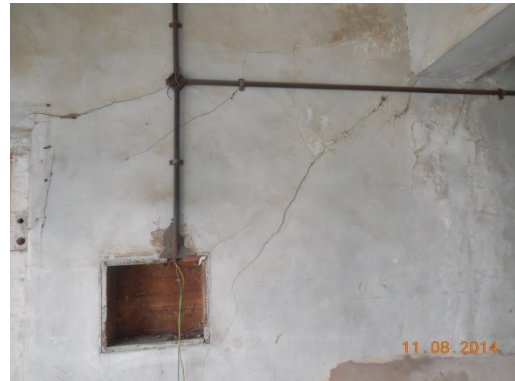
Photo 10A

Inclind Crack on Wall No.4 of Varanda No. 2 of Hind Hotel, Third floor, Approx. Width=1.5mm, Approx.Length=4.0m. Distance from Wall No.1=0.0m, Height from Floor=1.3m.

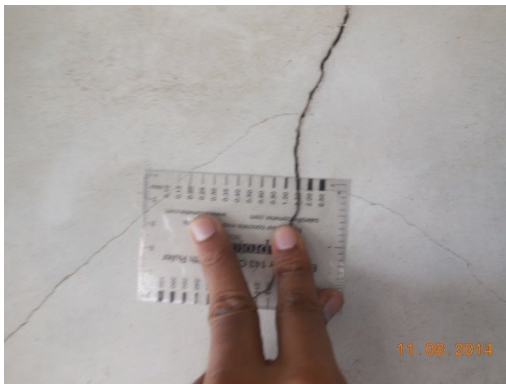
Photo 10B

Inclind Crack on Wall No.4 of Varanda No. 2 of Hind Hotel, Third floor, Approx. Width=1.5mm, Approx.Length=4.0m. Distance from Wall No.1=0.0m, Height from Floor=1.3m.

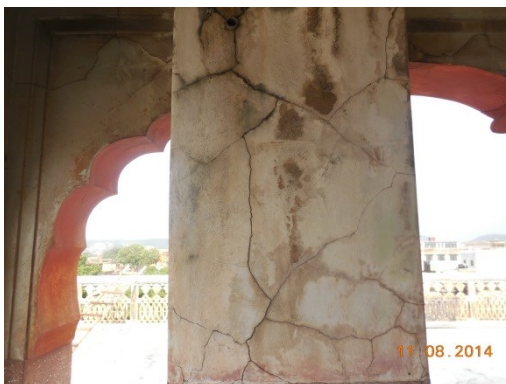
Photo 11B

Inclind Crack on Wall No.2 of Varanda No. 3 of Hind Hotel, Third floor, Approx. Width=2.5mm, Approx.Length=3.0m. Distance from Wall No.3=0.0m, Height from Floor=2.0m.

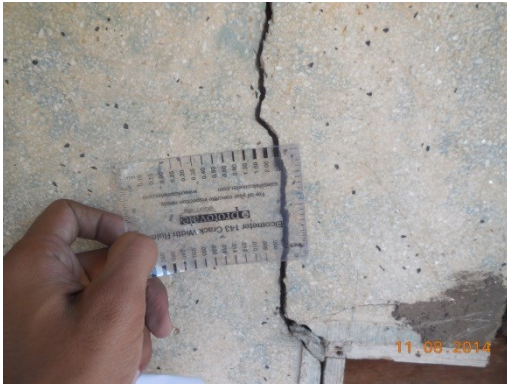
Photo 12B

Inclined Crack on Wall No.1 of Varanda No. 3 of Hind Hotel, Third floor, Approx. Width=2.5mm, Approx.Length=1.8m. Distance from Wall No.4=0.3m, Height from Floor=1.5m.

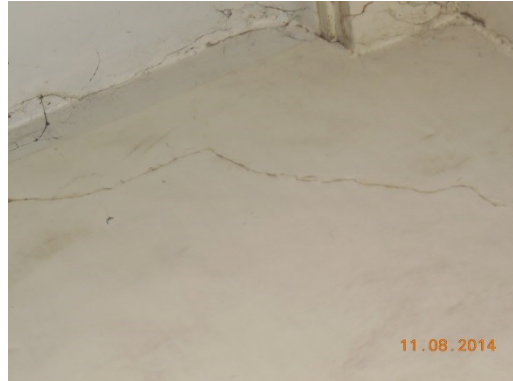
Photo 13

Inclined Crack on Wall No.1 to Roof of Room No. 3 of Hind Hotel, First floor, Approx. Width=0.8mm, Approx.Length=3.0m. Distance from Wall No.4=0.0m, Height from Floor=2.6m.

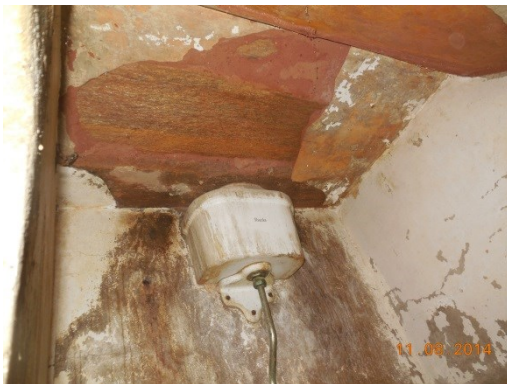
Photo 14

Plaster Removal on Roof of Toilet of Hind Hotel, Ground Floor

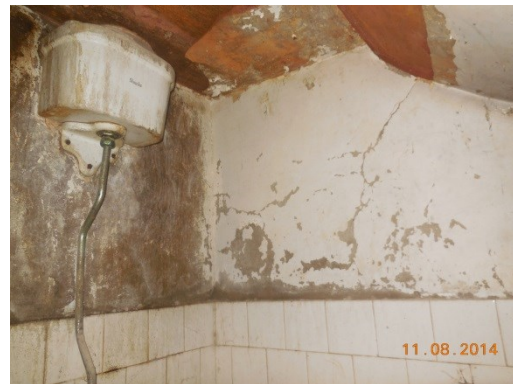
Photo 15

seepage on Wall No. 1 & 4 of Toilet of Hind Hotel, Ground Floor

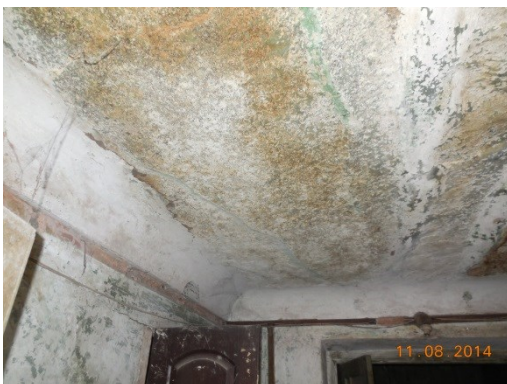
Photo 16

Seepage on Roof of Room No. 1 of Hind Hotel, Ground Floor

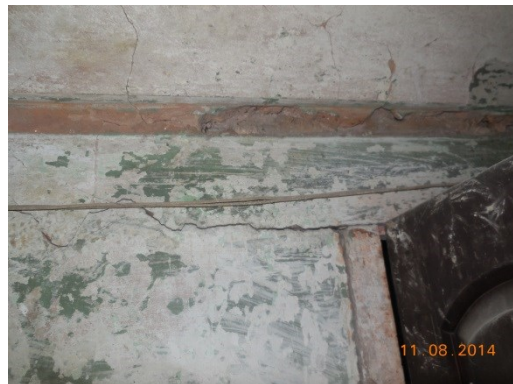
Photo 17

Plaster Removal on Wall No. 1 of Room No. 1 of Hind Hotel, Ground Floor

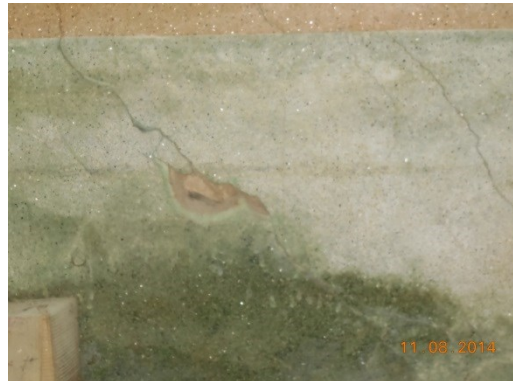
Photo 19

Plaster Removal on Wall No. 4 of Room No. 2 of Hind Hotel, Ground Floor

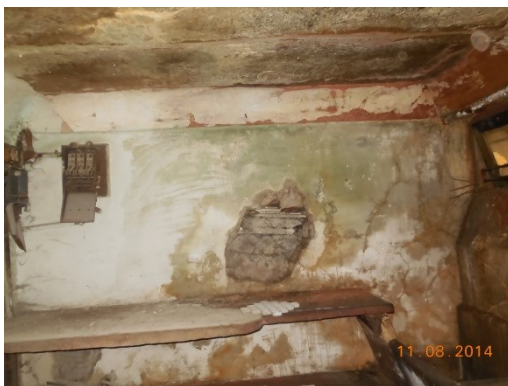
Photo 20

Plaster Removal on Wall No. 2 of Room No. 1 of Hind Hotel, Ground Floor

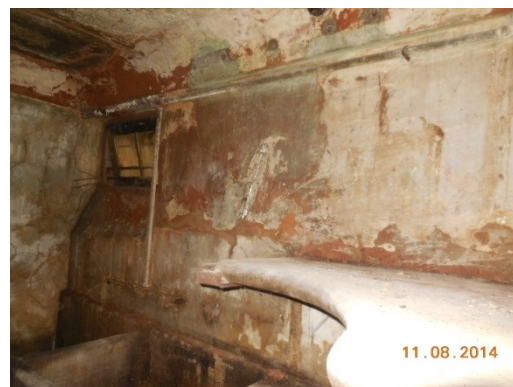
Photo 21

Plaster Removal on Wall No. 3 of Room No. 1 of Hind Hotel, Ground Floor

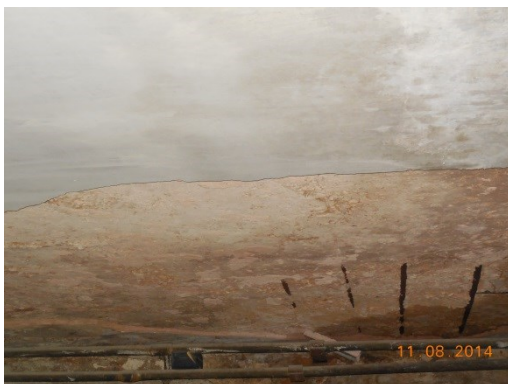
Photo 22

Expose Reinforcement on Roof of Room No. 5 of Hind Hotel, Ground Floor

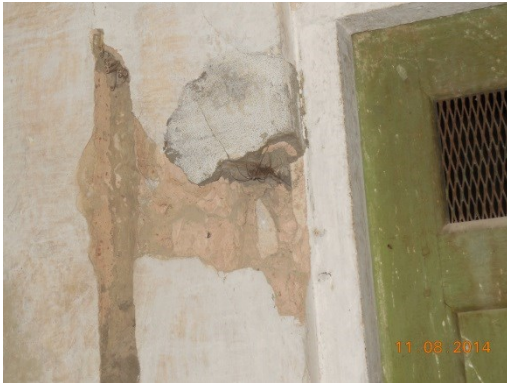
Photo 24

Plaster Removal on Wall No. 4 of Room No. 5 of Hind Hotel, Ground Floor

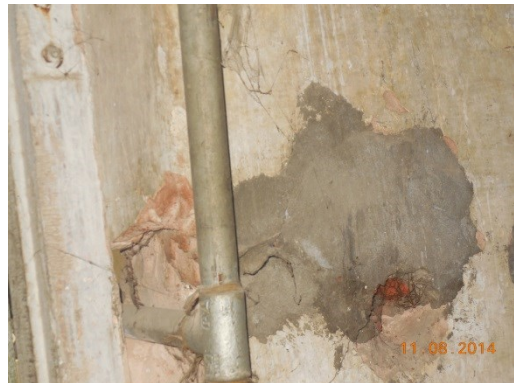
Photo 25

Plaster Removal on Wall No. 3 of Room No. 5 of Hind Hotel, Ground Floor

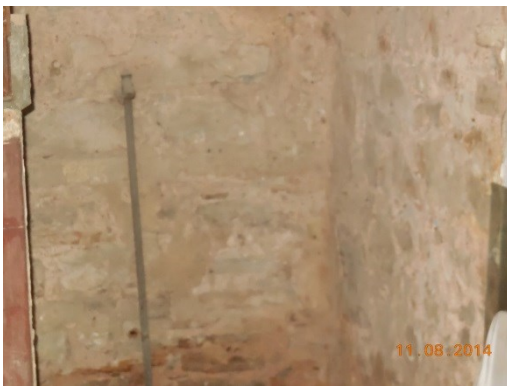
Photo 26

Plaster Removal on All Walls of Store No.2 of Hind Hotel, Ground Floor

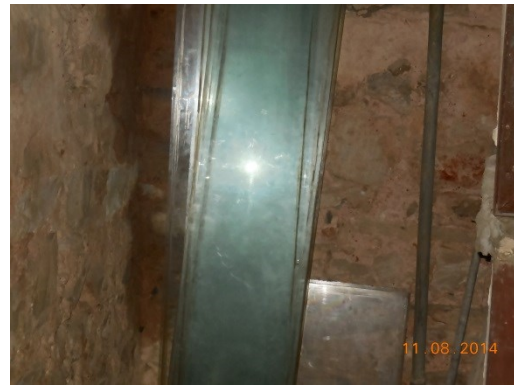
Photo 27

Plaster Removal on All Walls of Store No. 1 of Hind Hotel, Ground Floor

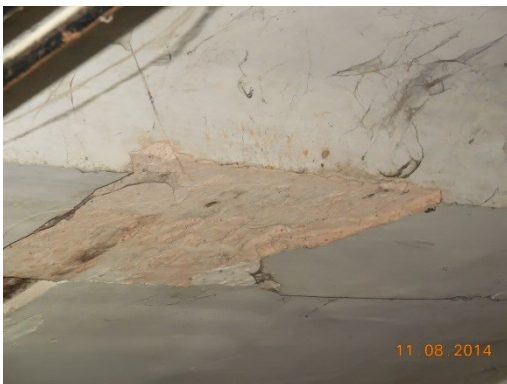
Photo 28

Plaster Removal on Roof of Room No. 4, Part B of Hind Hotel, Ground Floor

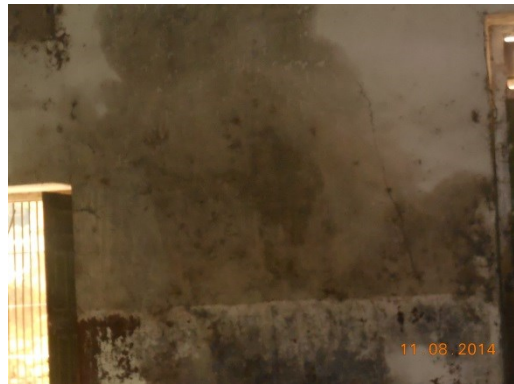
Photo 29

Seepage on Wall No.4 of Room No. 4, Part C of Hind Hotel, Ground floor

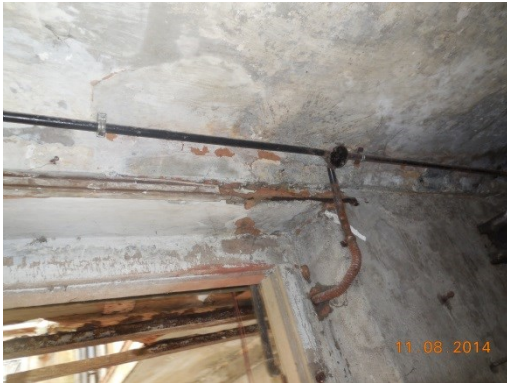
Photo 30

Plaster Removal on Wall No. 3 of Room No. 4, Part C of Hind Hotel, Ground Floor

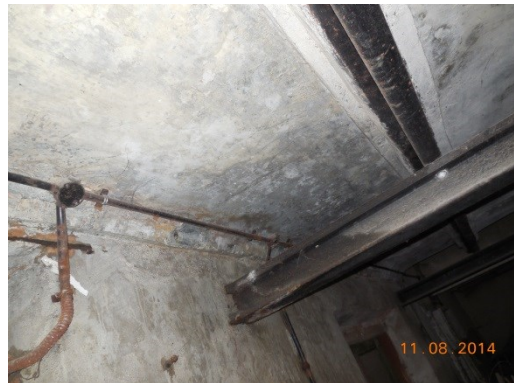
Photo 31

Seepage on Roof of Room No. 4, Part C of Hind Hotel, Ground floor

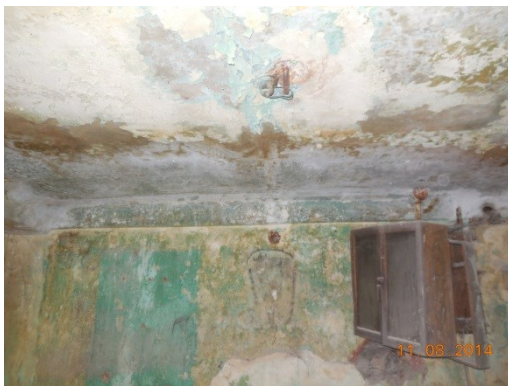
Photo 32

Seepage on Wall No. 4 & Roof of Room No. 7 of Hind Hotel, Ground floor

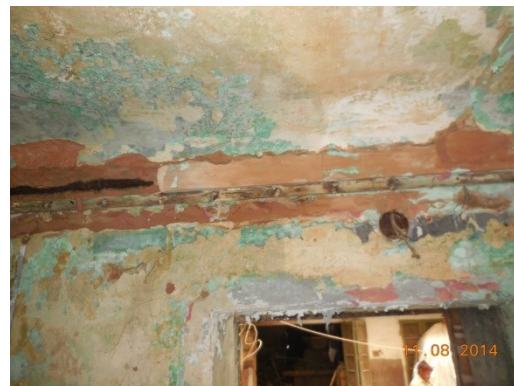
Photo 33

Plaster Removal on Wall No. 3 of Room No. 7 of Hind Hotel, Ground Floor

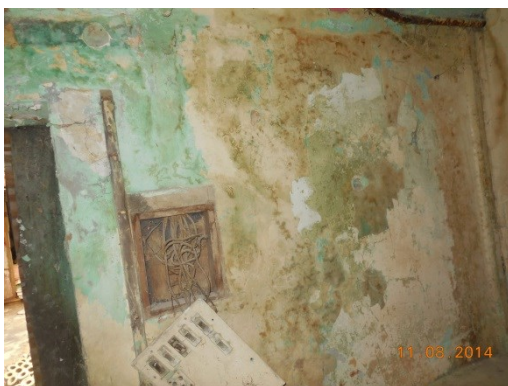
Photo 34

Seepage on Wall No. 3 of Room No. 7 of Hind Hotel, Ground floor

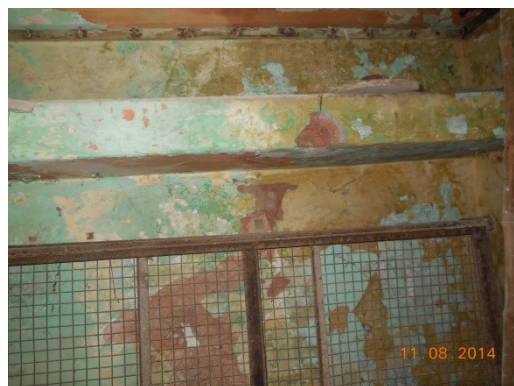
Photo 35

Seepage on Wall No. 2 of Room No. 7 of Hind Hotel, Ground floor

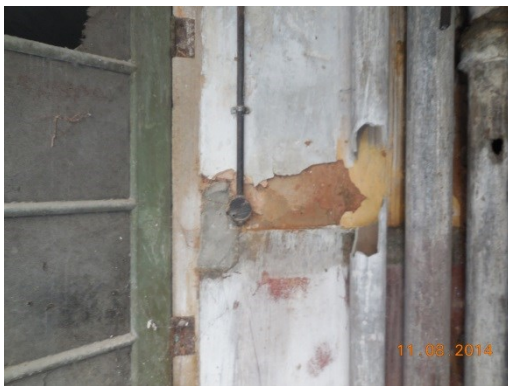
Photo 38

Plaster Removal on Wall No. 4 of Courtyard of Hind Hotel, Ground Floor

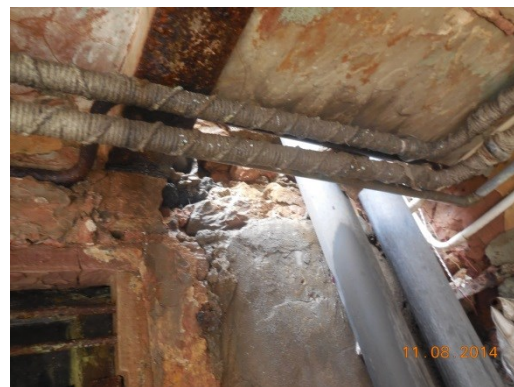
Photo 40

Damage on Shade of Courtyard of Hind Hotel, Ground Floor

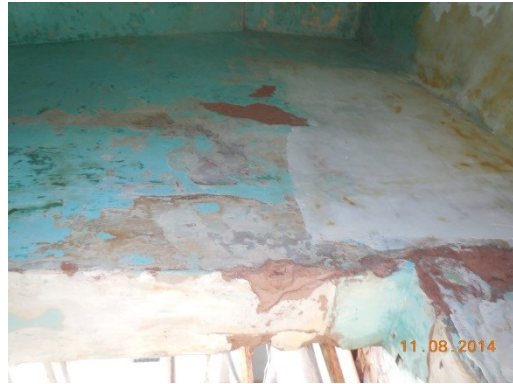
Photo 42

Seepage on Wall No. 1 of Staircase of Hind Hotel, Ground floor

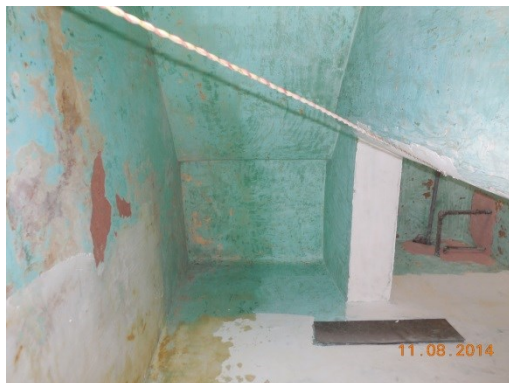
Photo 43

Plaster Removal on Wall No. 1 of Staircase of Hind Hotel, Ground Floor

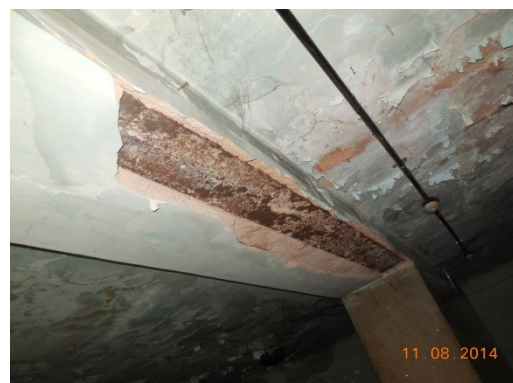
Photo 44

Seepage on Wall No. 4 & Roof of Staircase of Hind Hotel, Ground Floor

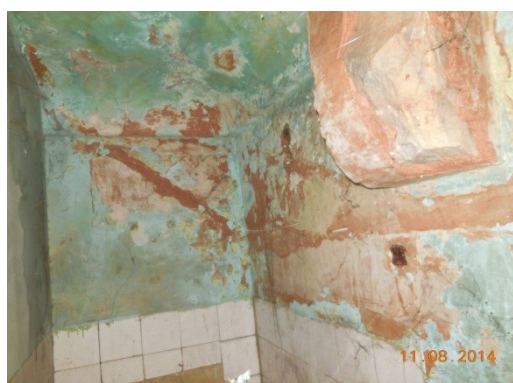
Photo 46

Plaster Removal on Wall No.4 of Room No. 1 of Hind Hotel, Mazzanin Floor

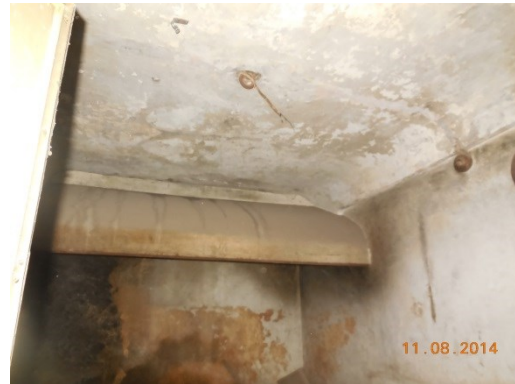
Photo 48

Plaster Removal on Wall No.1 of Room No. 1 of Hind Hotel, Mazzanin Floor

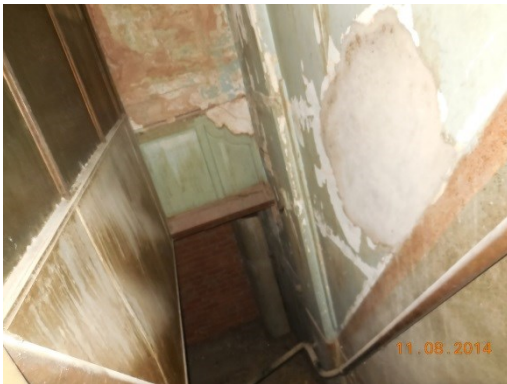
Photo 49

Seepage on All Walls & Roof of Room No. 2 of Hind Hotel, Mazzanin Floor

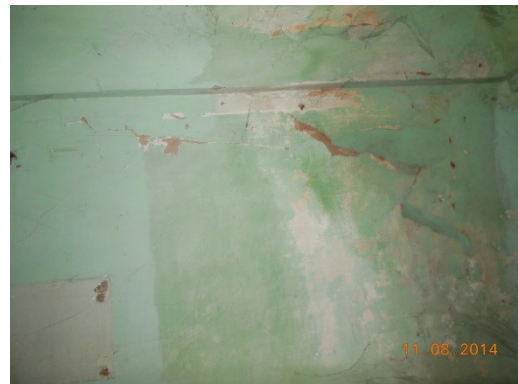
Photo 50

Seepage on All Walls & Roof of Staircase No. 2 of Hind Hotel, Mazzanin Floor

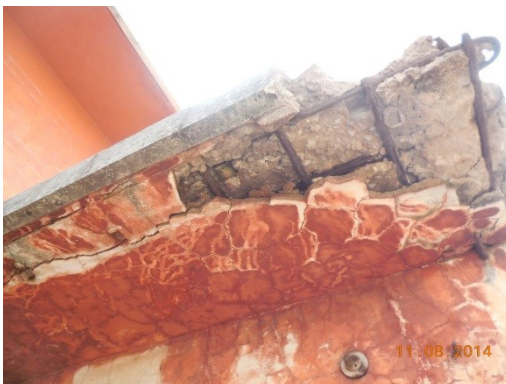
Photo 51

Seepage on Wall No. 2 of Room No. 2 of Hind Hotel, Mazzanin Floor

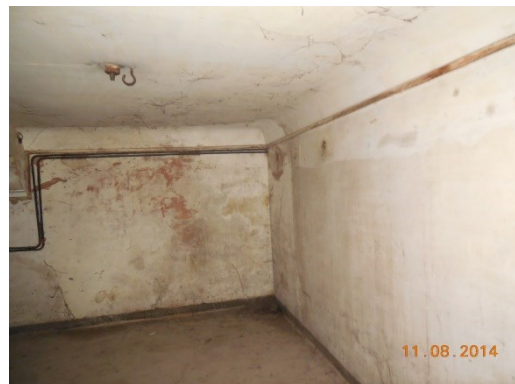
Photo 52

Seepage on Wall No. 1 & 3 of Room No. 3 of Hind Hotel, Mazzanin Floor

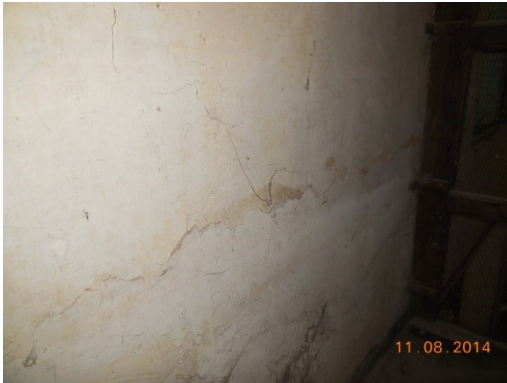
Photo 54

Peeling of Plaster on Wall No. 3 of Room No. 4 of Hind Hotel, Mazzanin Floor

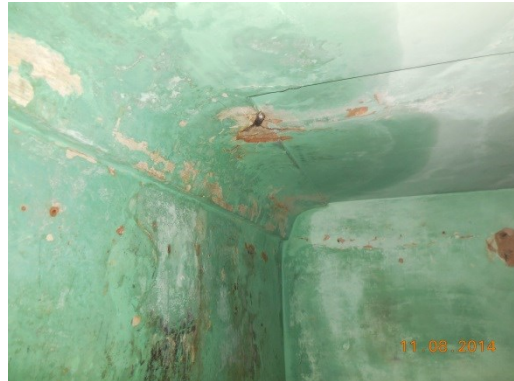
Photo 55

Seepage on Wall No. 1, 3 & Roof of Room No. 5 of Hind Hotel, Mazzanin Floor

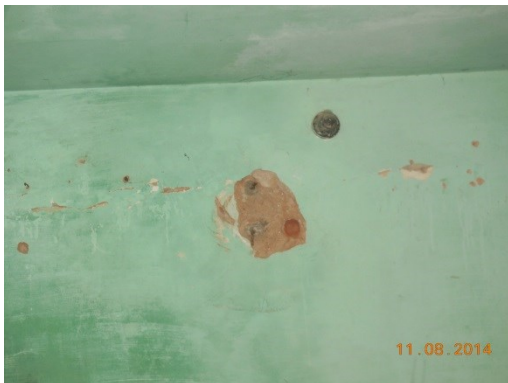
Photo 56

Plaster Removal on Wall No. 1 of Room No. 5 of Hind Hotel, Mazzanin Floor

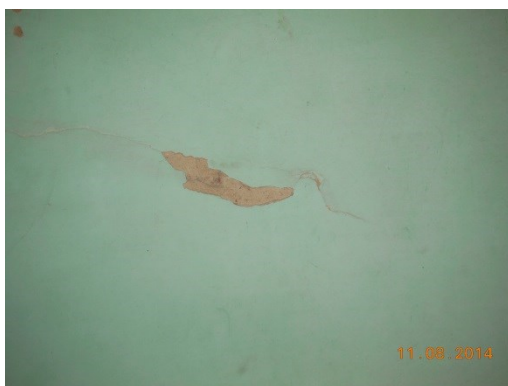
Photo 58

Plaster Removal on Wall No. 4 of Room No. 5 of Hind Hotel, Mazzanin Floor

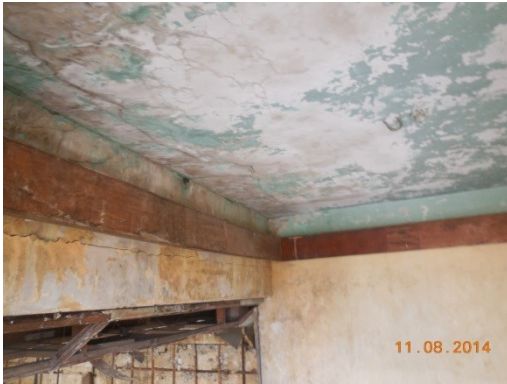
Photo 60

Plaster Removal on Wall No. 1 of Lobby of Hind Hotel, Mazzanin Floor

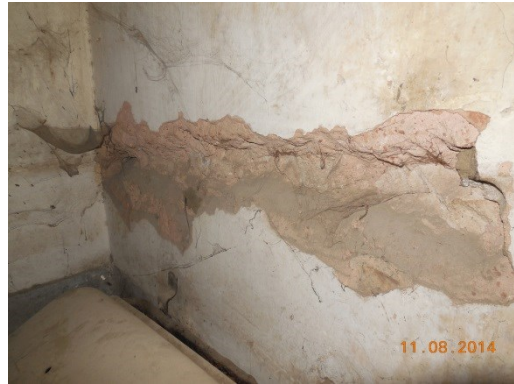
Photo 61

Plaster Removal on Wall No. 2 of Toilet No.1 of Hind Hotel, Mazzanin Floor

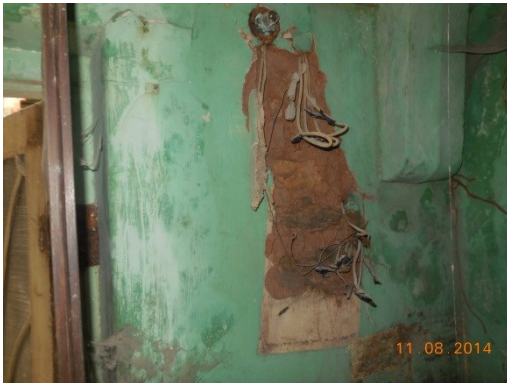
Photo 62

Plaster Removal on Wall No. 3 of Room No.1 of Hind Hotel, Mazzanine Floor

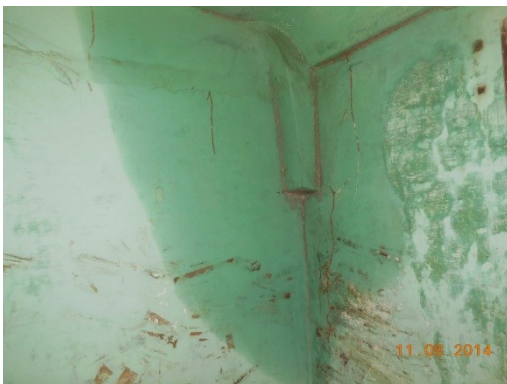
Photo 64

Seepage on Wall No. 2 & 3 of Room No.6 of Hind Hotel, Mazzanine Floor

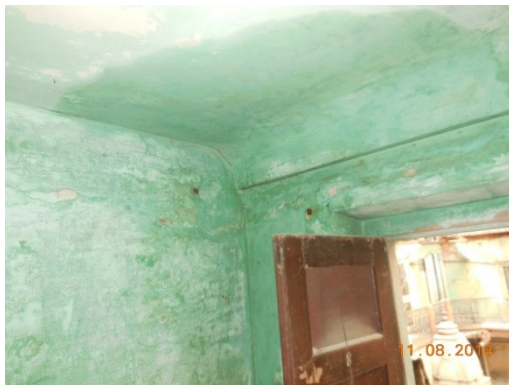
Photo 66

Seepage on Wall No.2 & 3 of Room No.7 of Hind Hotel,
Mazzanine Floor

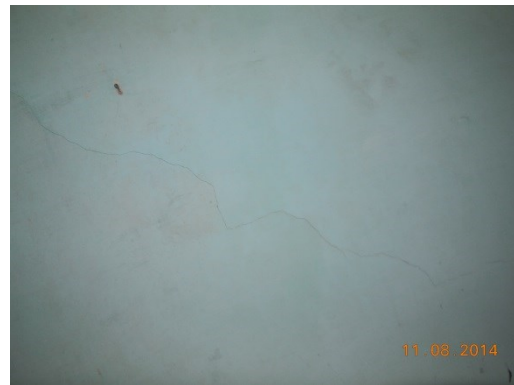
Photo 67

Plaster Crack on Wall No.1 of Room No.7 of Hind Hotel,
Mazzanine Floor

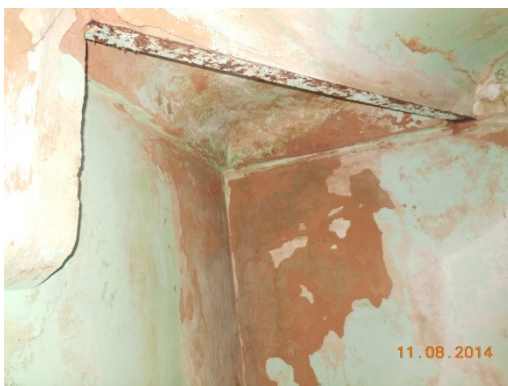
Photo 68

Seepage on Wall No. 2,3 & Roof of Room No.8 of Hind Hotel,
Mazzanine Floor

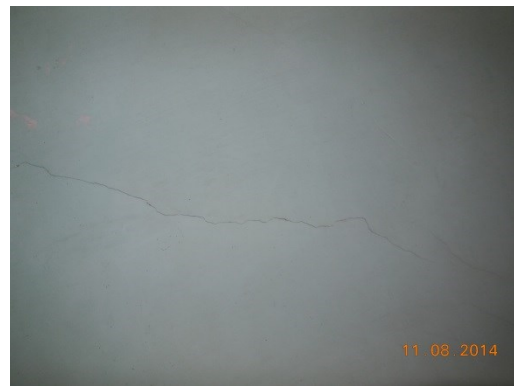
Photo 69

Plaster Crack on Wall No.1 of Room No.8 of Hind Hotel,
Mazzanine Floor

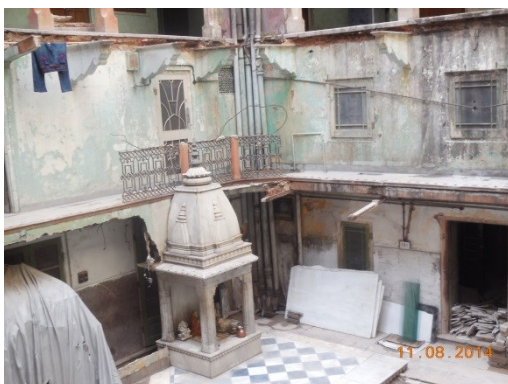
Photo 70

Damage on Railing of Corridor of Hind Hotel, Mazzanine Floor

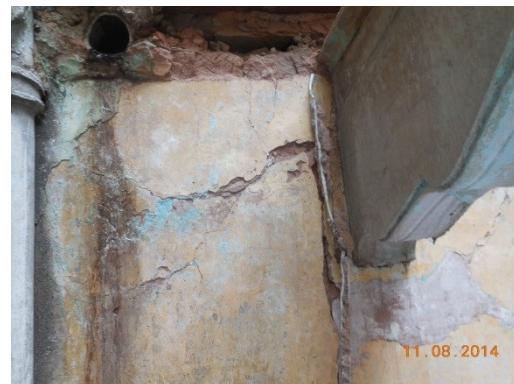
Photo 71

Damage on Wall No.1 of Corridor of Hind Hotel, Mazzanine Floor

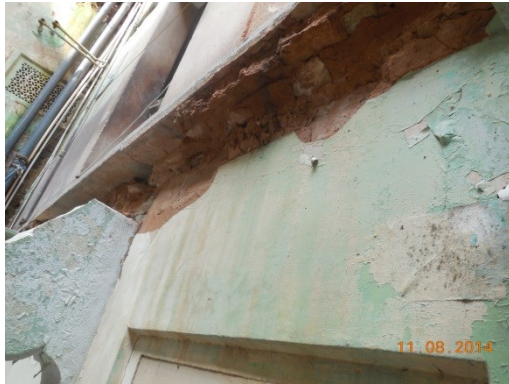
Photo 72

Damage on Wall No.3 of Corridor of Hind Hotel, Mezzanine Floor

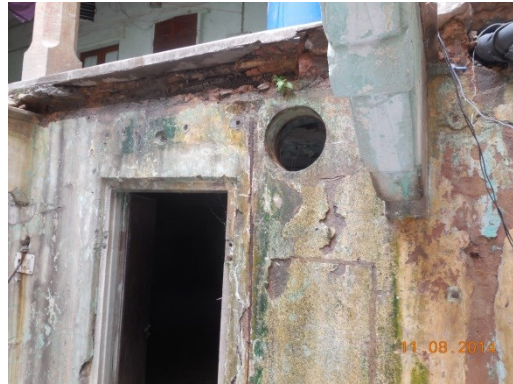
Photo 73

Seepage on Wall No.2 of Corridor of Hind Hotel, Mezzanine Floor

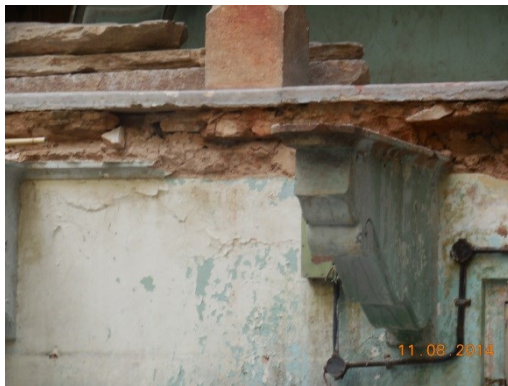
Photo 74

Damage on Wall No.4 of Corridor of Hind Hotel, Mezzanine Floor

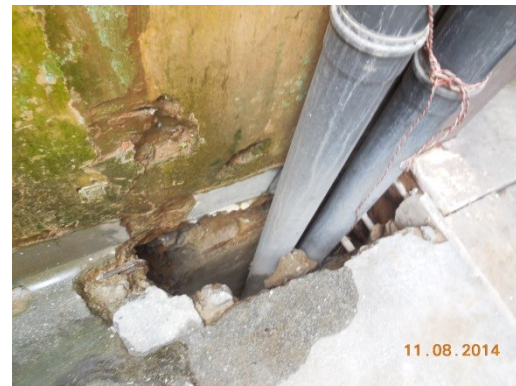
Photo 75

Damage on Floor of Corridor of Hind Hotel, Mezzanine Floor

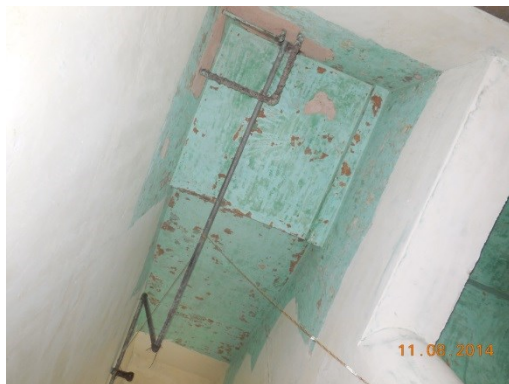
Photo 76

Seepage on Roof of Staircase of MSN to FF of Hind Hotel, Mezzanine Floor

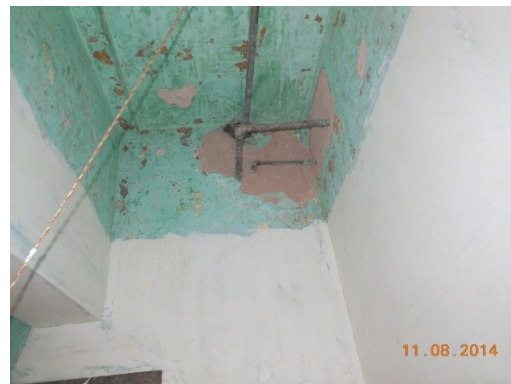
Photo 77

Seepage on Wall No. 3 of Staircase MSN to FF of Hind Hotel Mezzanine Floor

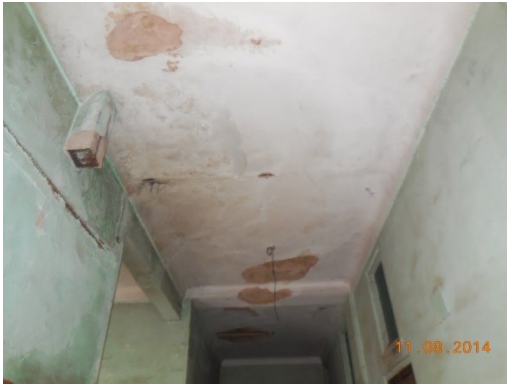
Photo 78

Plaster Removal on Roof of Varanda No. 3 of Hind Hotel, First Floor

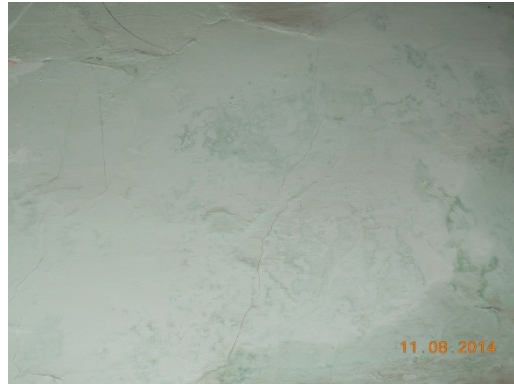
Photo 79

Plaster Crack on Wall No. 3 of Varanda No. 3 of Hind Hotel, First Floor

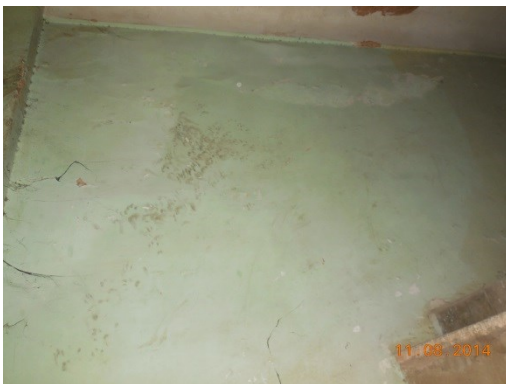
Photo 80

Seepage on Wall No. 3 of Varanda No. 3 of Hind Hotel, First Floor

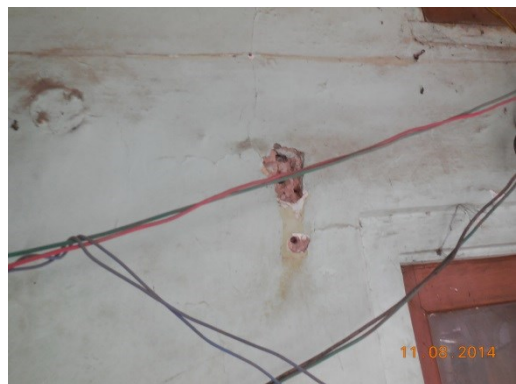
Photo 81

Plaster Removal on Wall No. 4 of Varanda No. 3 of Hind Hotel, First Floor

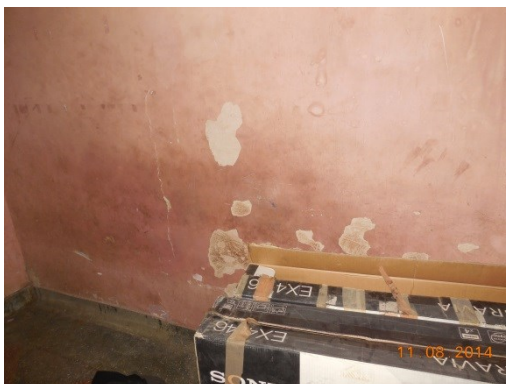
Photo 82

Peeling Plaster on Wall No.2 of Room No.13 of Hind Hotel, First Floor

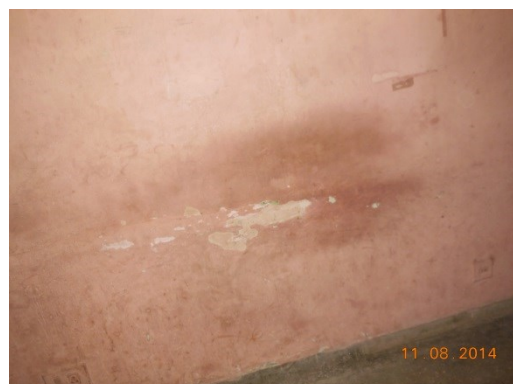
Photo 83

Peeling Plaster on Wall No.1 of Room No.13 of Hind Hotel, First Floor

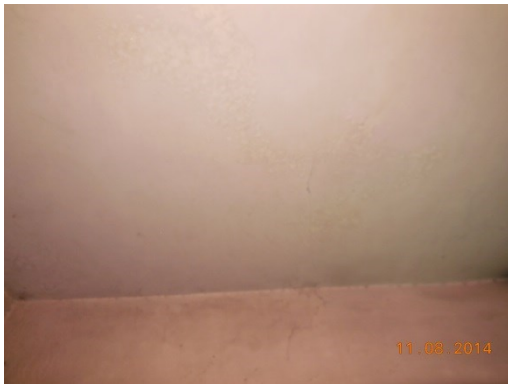
Photo 84
Seepage on Roof of Room No. 13 of Hind Hotel,
First Floor

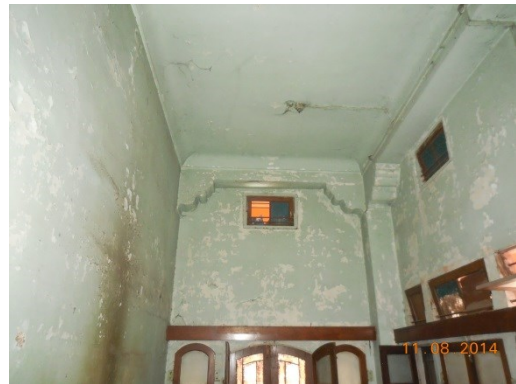
Photo 85
Peeling Plaster on All Walls of Room No. 19 of Hind Hotel,
First Floor

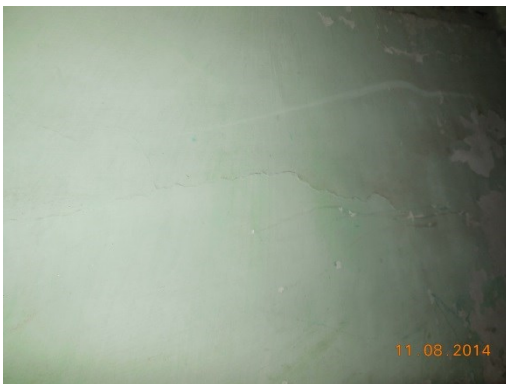
Photo 86
Plaster Crack on Wall No. 1 of Passage No. 3 of Hind Hotel, ,
First Floor

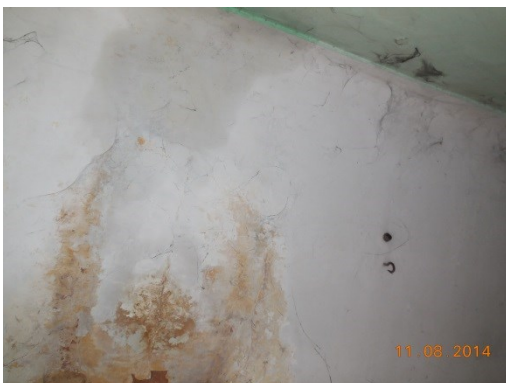
Photo 88
Seepage on Roof of Varanda No. 4 of Hind Hotel,
First Floor

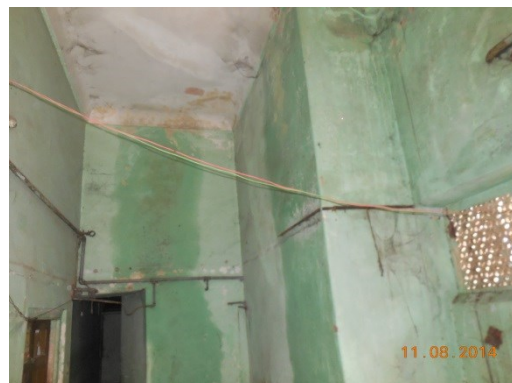
Photo 89
Seepage on Wall No. 2 & 3 of Varanda No. 4 of Hind Hotel,
First Floor

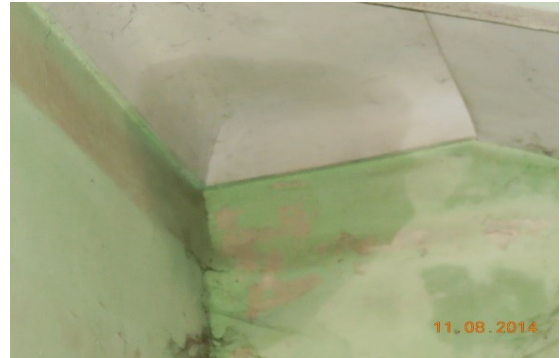
Photo 91

Seepage on Wall No. 1 & Roof of Varanda No. 4 of Hind Hotel,
First Floor

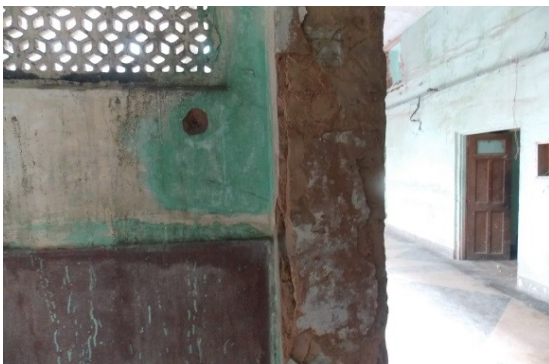
Photo 92

Plaster Removal on Wall No. 2 of Varanda No. 2 of Hind Hotel,
First Floor

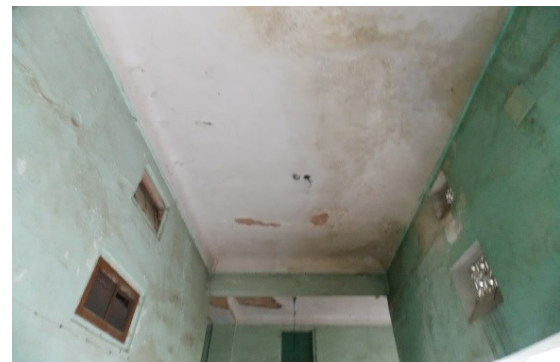
Photo 93

Plaster Removal on Roof of Varanda No. 2 of Hind Hotel,
First Floor

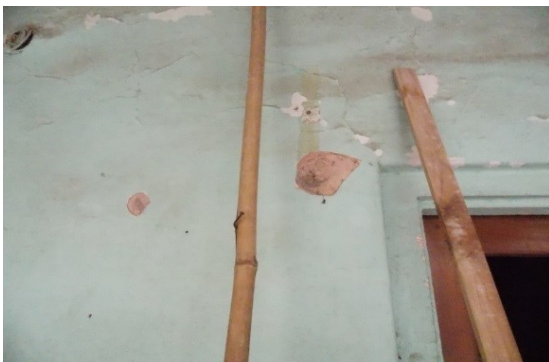
Photo 94

Plaster Removal on Wall No. 2 of Varanda No. 2 of Hind Hotel,
First Floor

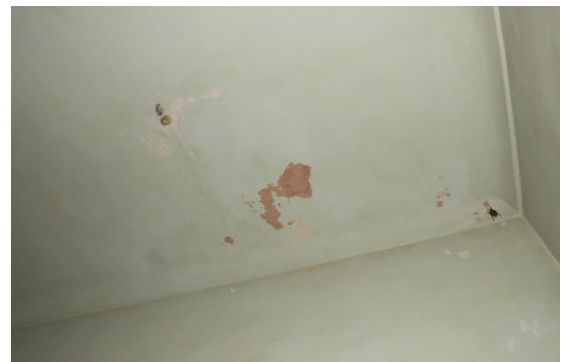
Photo 95

Plaster Removal on Roof of Room No. 8 of Hind Hotel,
First Floor

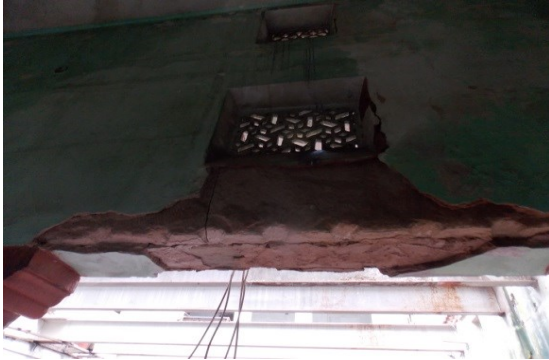
Photo 96

Plaster Removal on Wall No. 2 of Varanda No. 2 of Hind Hotel, First Floor

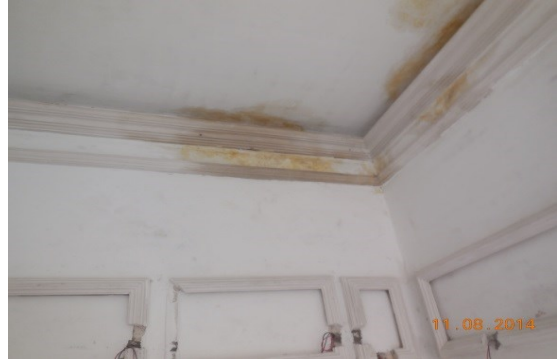
Photo 97

Seepage on Wall No. 1, 2 & Roof of Room No. 2 of Hind Hotel, Second Floor

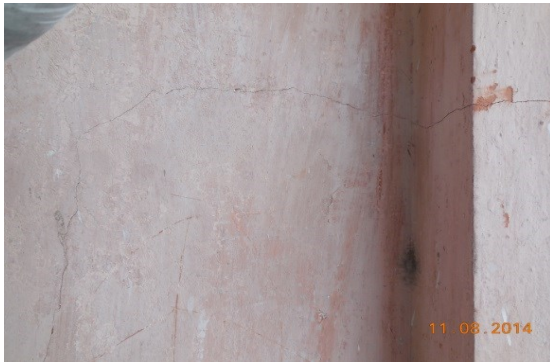
Photo 98

Plaster Crack on Wall No. 1 of Balcony of Room No. 3 of Hind Hotel, Second Floor

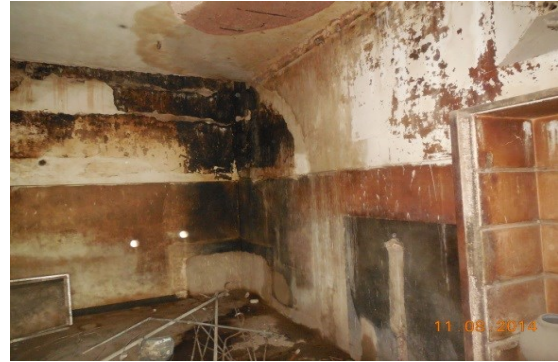
Photo 99

Seepage on Wall No. 2 & 4 of Room No. 7 of Hind Hotel, Second Floor

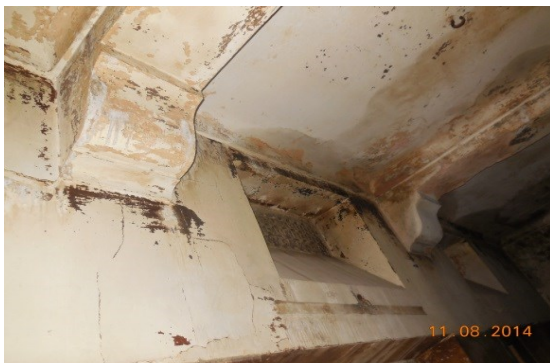
Photo 100

Seepage on Wall No. 3 & Roof of Room No. 7 of Hind Hotel, Second Floor

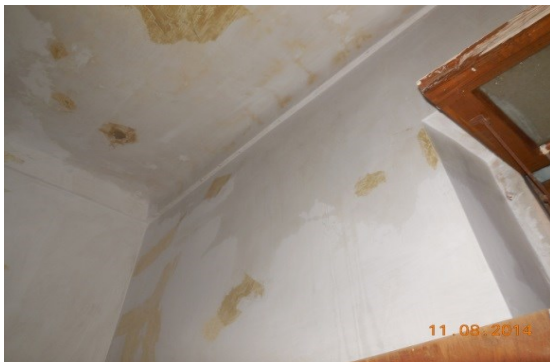
Photo 104
Seepage on Wall No.3 & Roof of Room No. 12 of Hind Hotel,
Second Floor

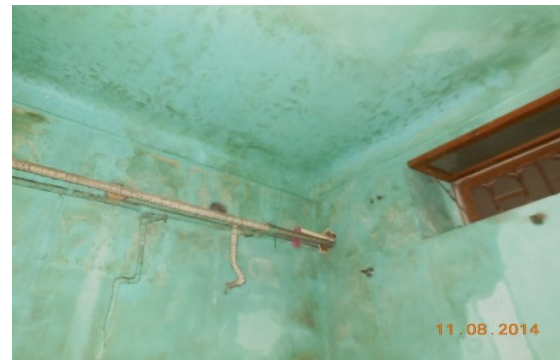
Photo 105
Seepage on All Walls of Toilet & Bath of Room No.12 of Hind Hotel,
Second Floor
