Pre Building Condition Survey Report

Name and Address of Structure :	Choti Chopar to Badi Chopar (Down Line)
---------------------------------	---

Name of the Project	Contract JMRC-UG1B “Design and Construction of Tunnel between Chandpole and Badi Chouper and reverse line by Shield TBM, Underground Metro Stations at Choti Chouper and Badi Chouper by Cut and Cover Methods on East West Corridor of Jaipur Metro Rail Corporation Limited .”	
Owner :

Pre Building Condition Survey Report Choti Chopar to Badi Chopar (Down Line)

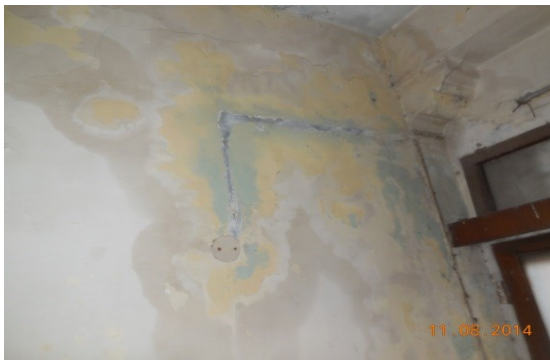
Photo 106
Seepage on Wall No. 3 & 5 of Room No. 13 of Hind Hotel, Second
Floor

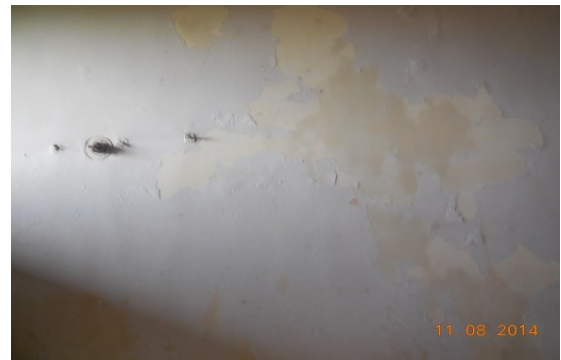
Photo 107
Peeling of Plaster on Wall No. 2 of Room No. 13 of Hind Hotel,
Second Floor

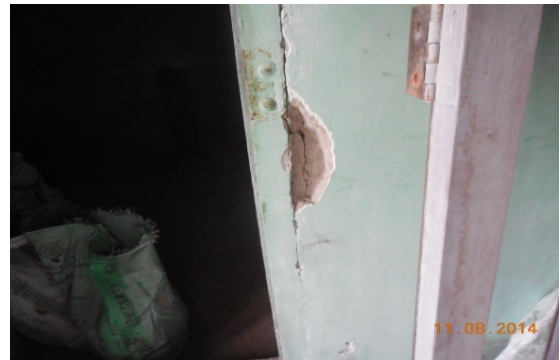
Photo 109
Plaster Removal on Wall No. 2 of Room No. 14 of Hind Hotel,
Second Floor

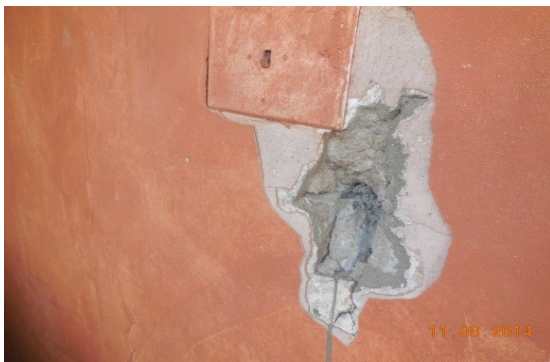
Photo 110
Plaster Removal on Balcony of Room No. 14 of Hind Hotel, Second
Floor

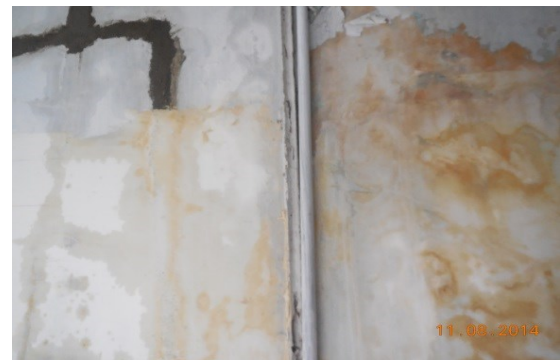
Photo 111
Seepage on Wall No. 2 of Varanda No. 1 of Hind Hotel, Second Floor

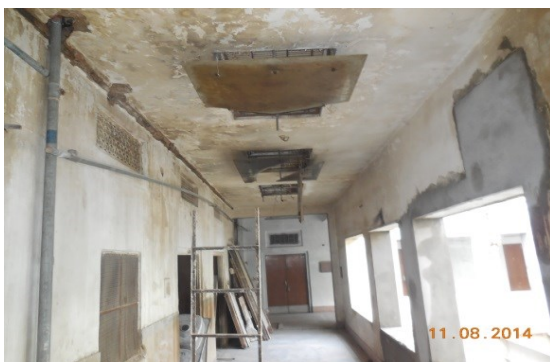
Photo 112
Seepage on All Walls of Varanda No. 2 of Hind Hotel,
Second Floor

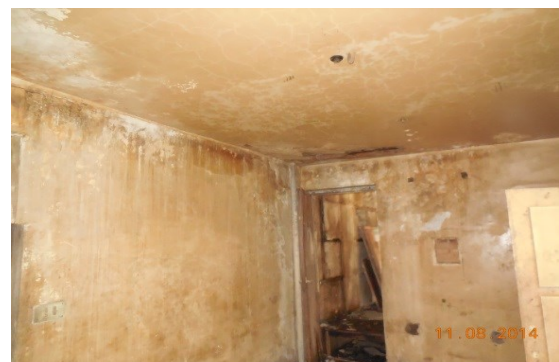
Photo 113
Seepage on All Walls of Room No. 2 of Hind Hotel,
Third Floor

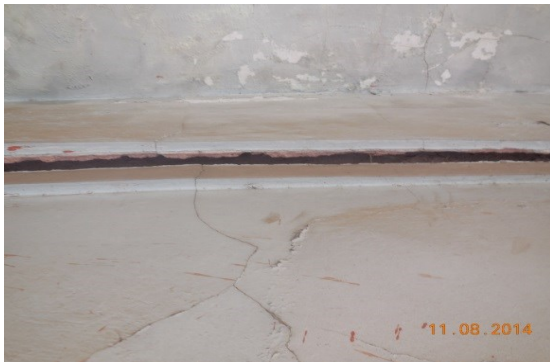
Photo 116
Plaster Removal on Wall No.4 of Varanda No. 3 of Hind Hotel
Third Floor

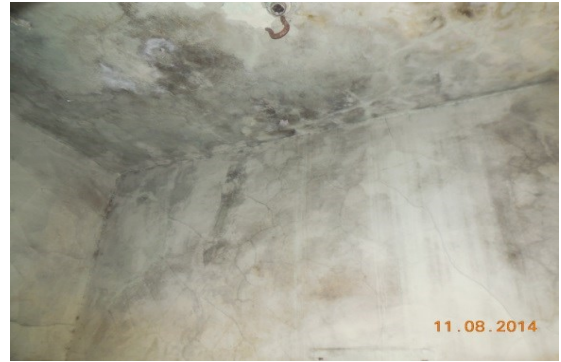
Photo 117
Seepage on All Walls & Roof of Toilet of Hind Hotel,
Third Floor

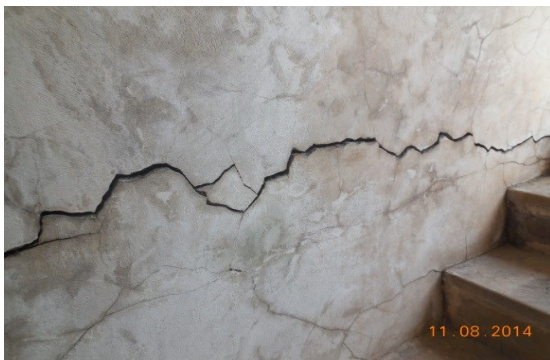
Photo 118
Plaster Removal on Wall No.1 & 4 of Staircase of Hind Hotel,
Third Floor

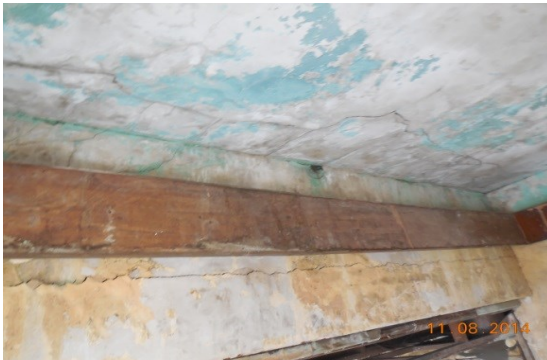
Photo 120
Damage on Wall No.2 & 3 of Room No. 1 of Hind Hotel, Terrace

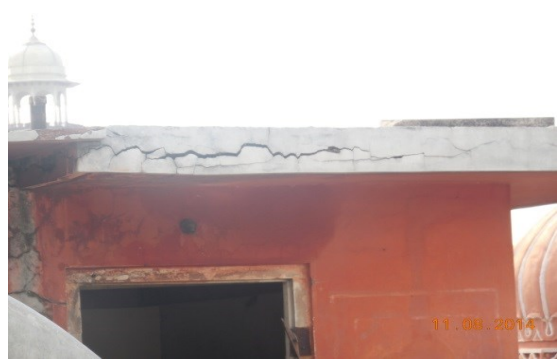
Photo 121
Damage on Shade of Room No. 1 of Hind Hotel, Terrace

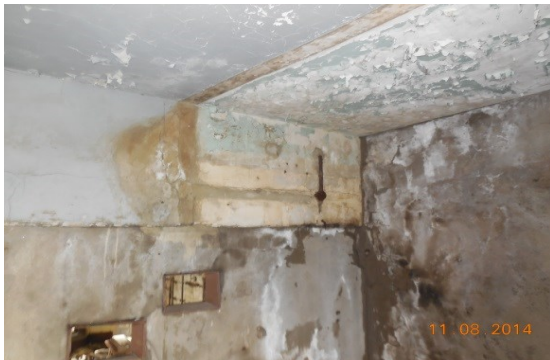
Photo 122
Seepage on All Walls & Roof of Room No. 2 of Hind Hotel, Terrace

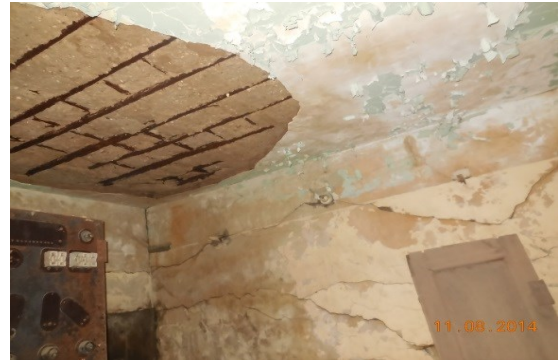
Photo 123
Damage on Wall No. 4 & Roof of Room No. 3 of Hind Hotel, Terrace

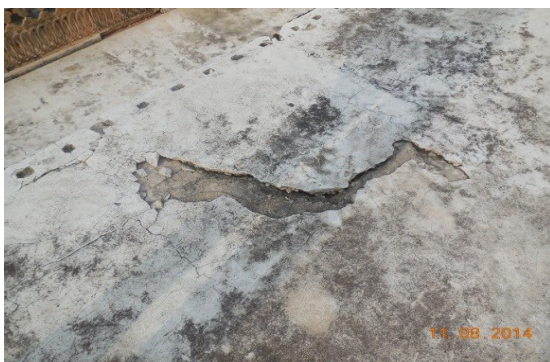
Photo 124
Damage on Floor of Terrace of Hind Hotel

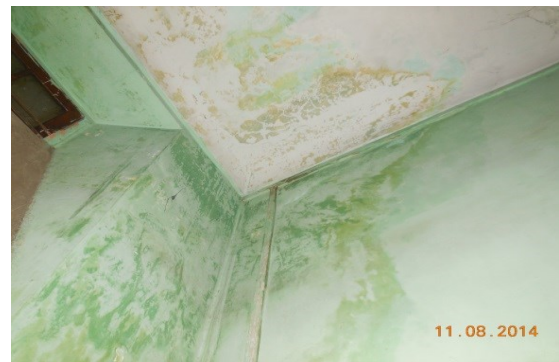
Photo 125
Seepage on Wall No. 1 & Roof of Room No. 2 of Hind Hotel,
First Floor

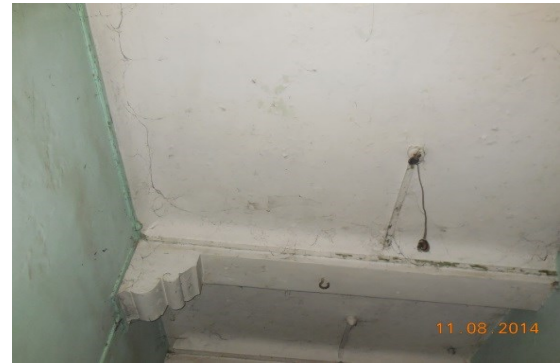
Photo 130

Seepage on Wall No. 2, 3 & Roof of Room No. 1 of Hind Hotel, First Floor

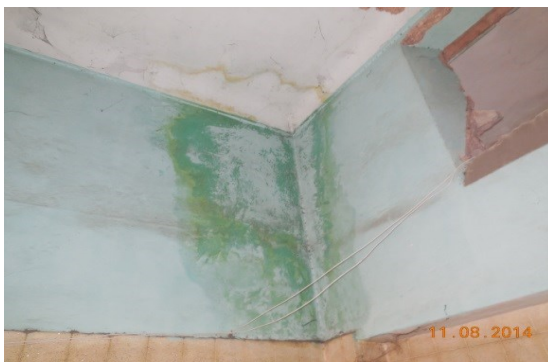
Photo 131

Plaster Removal on Roof of Room No. 1 of Hind Hotel, First Floor

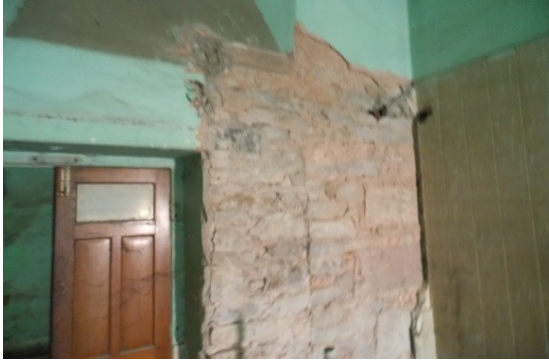
Photo 132

Plaster Removal on Wall No. 3 of Room No. 5 of Hind Hotel, First Floor

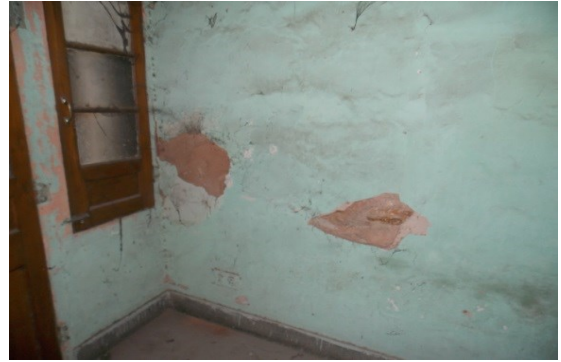
Photo 133

Plaster Removal on Wall No. 2 of Room No. 5 of Hind Hotel, First Floor

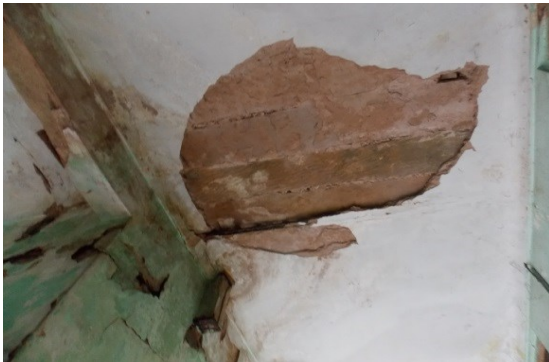
Photo 134

Plaster Removal on Roof of Varanda No. 1 of Hind Hotel, First Floor

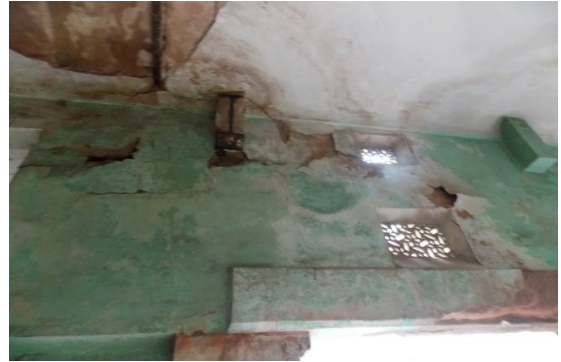
Photo 135

Plaster Removal on Wall No.2 of Varanda No.1 of Hind Hotel, First Floor

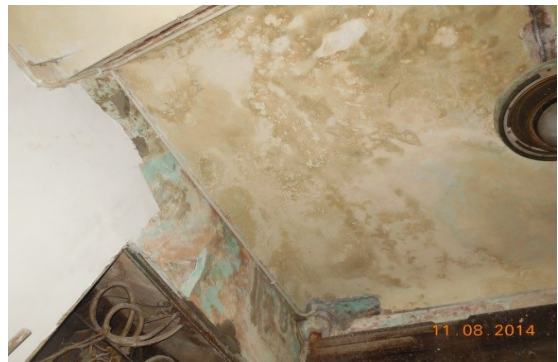
Photo 137

Seepage on Wall No.2 & Roof of Passage of Hind Hotel, Ground Floor

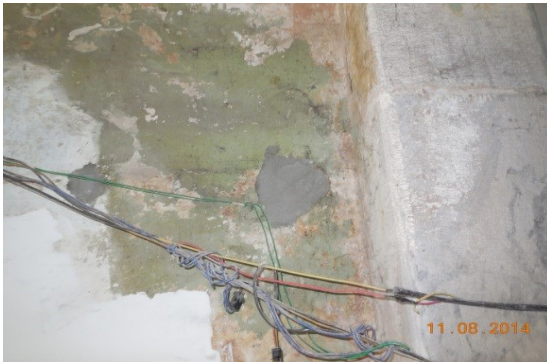
Photo 138

Repair Work on Wall No. 2 of of Passage of Hind Hotel,
Ground Floor

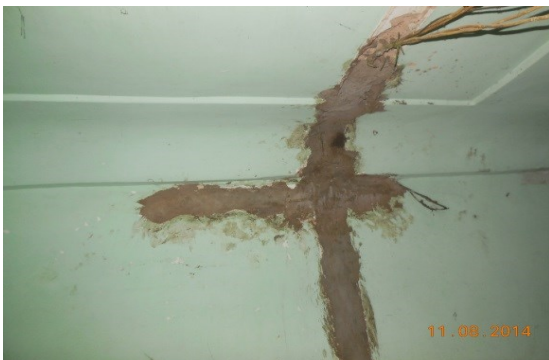
Photo 142

Repair Work on Wall No. 4 & Roof of Room No. 3 of Hind Hotel,
Mazzanin Floor

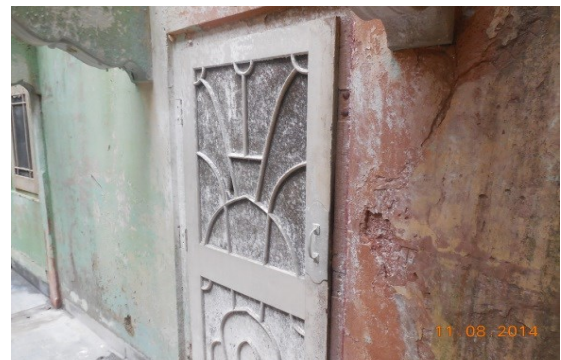
Photo 143

Jammed (Unable to open), Room No. 9 of Hind Hotel,
Mazzanine Floor,

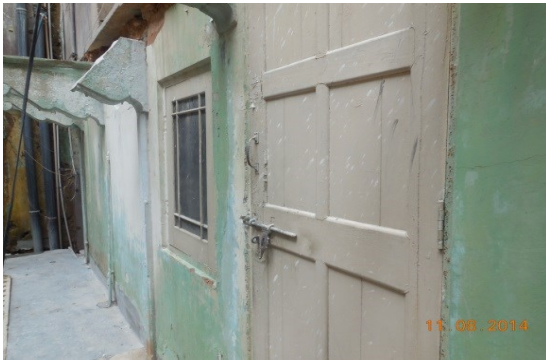
Photo 144

Jammed (Unable to open), Room No. 10 of Hind Hotel, Mazzanin Floor,

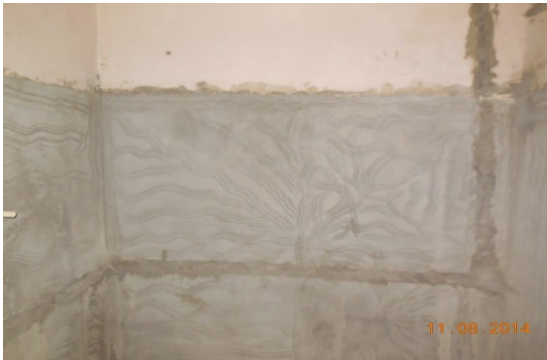
Photo 162

Under Construction, Toilet & Bath of Room No.5 of Hind Hotel, Second Floor,

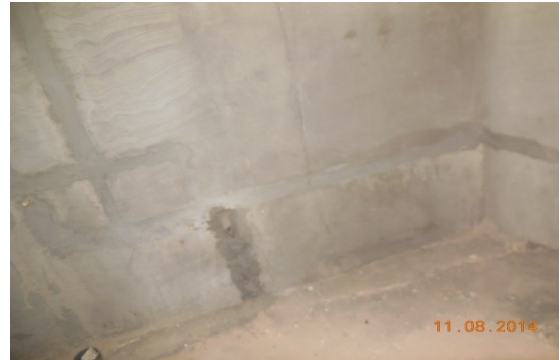
Photo 169

Under Construction, Toilet & Bath of Room No.14 of Hind Hotel, Second Floor,

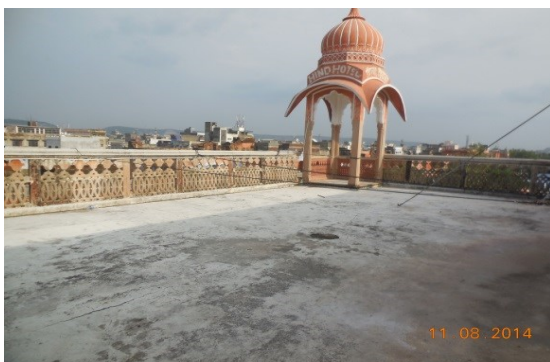
Photo 171

View of Hind Hotel, Terrace

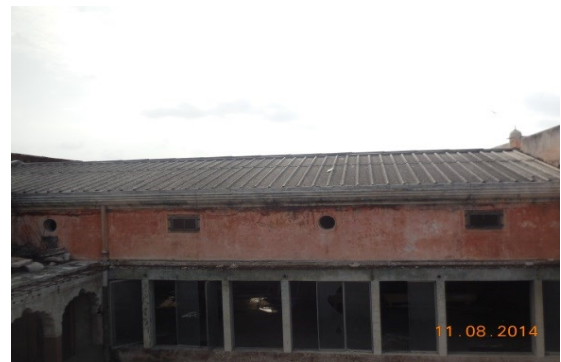
Photo 172

Protection By Roope from Callapse of Parafet wall of Terrace, Hind Hotel , Terrace

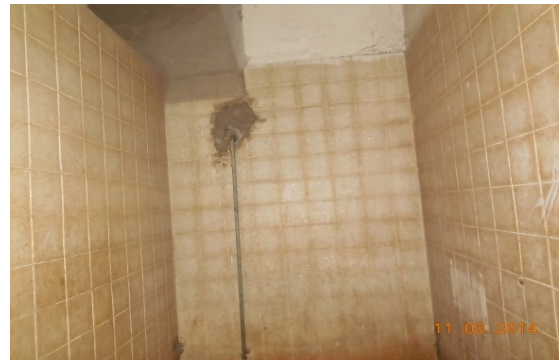
Photo 174

Covered with Tiles, All Walls of Toilet & Bath of Room No.2 of Hind Hotel, First Floor,

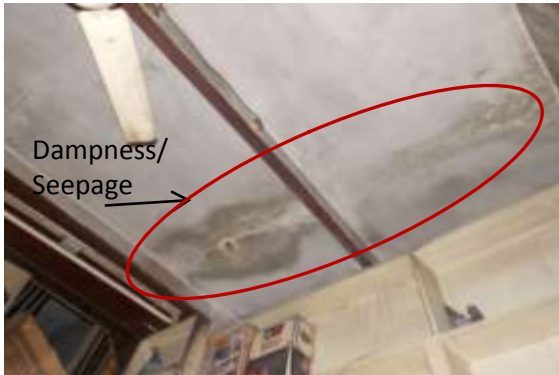
Photo 1

Dampness/Seepage on Roof of Shop No. 207, Ground Floor

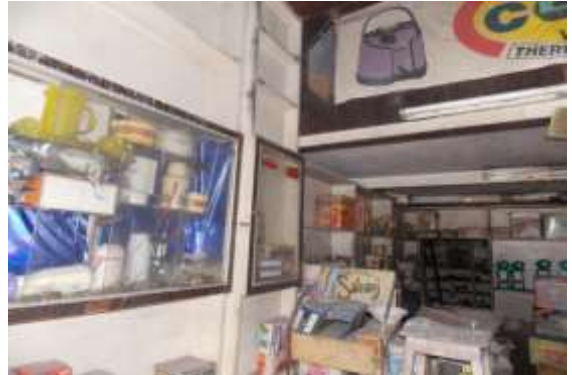
Photo 2

Covered with wooden and Material, Wall No. 1 & 4 of Shop No. 207, Ground Floor

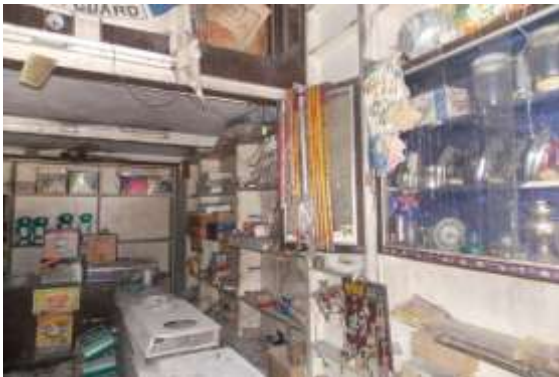
Photo 3

Covered with wooden and Material, Wall No. 2 & 4 of Shop No. 207, Ground Floor

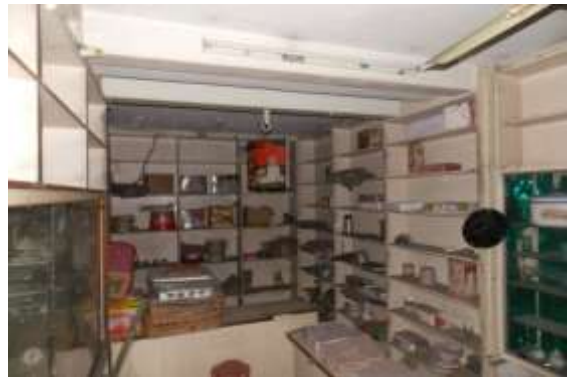
Photo 4

Covered with wooden and Material, Wall No. 2 & 4 of Shop No. 207, Basement

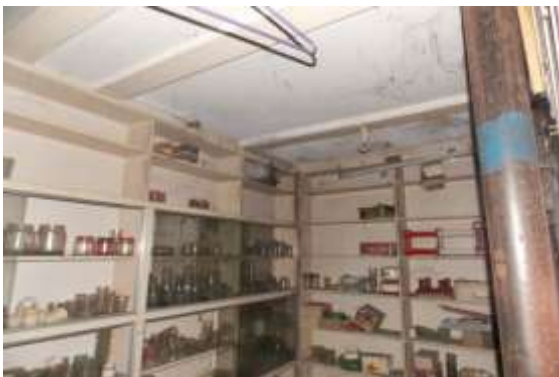
Photo 5

Covered with wooden and Material, Wall No. 2 & 3 of Shop No. 207, Basement

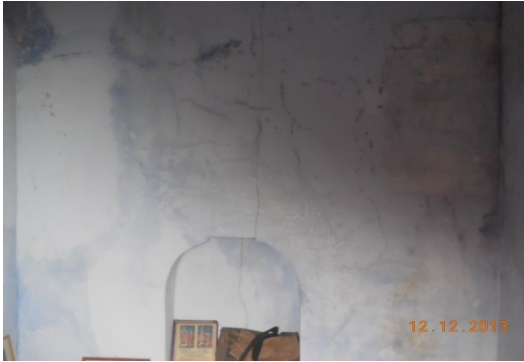
Photo 7

Vertical Crack on Wall No. 4 of Room No.2 of H.NO.481, Ground Floor, Approx. Width=1mm, Approx.Length=3.0m. Distance from Wall No.1=1.70m, Height from Floor=0m.

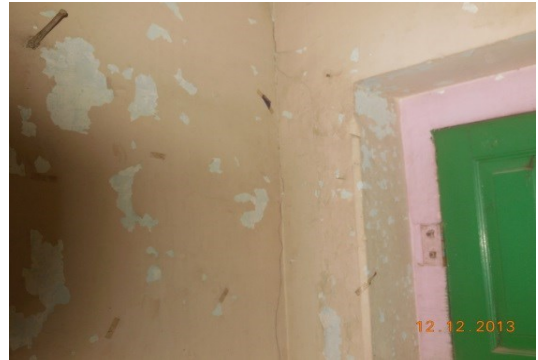
Photo 8A

Vertical Crack on Wall No.3 of Room No.2 of H.NO.481, First Floor, Approx. Width=1.0mm, Approx.Length=3.0m. Distance from Wall No.2=0m, Height from Floor=0.0m.

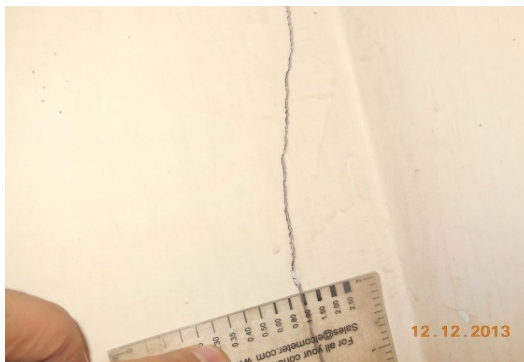
Photo 8B

Vertical Crack on Wall No.3 of Room No.2 of H.NO.481, First Floor, Approx. Width=1.0mm, Approx.Length=3.0m. Distance from Wall No.2=0m, Height from Floor=0.0m.

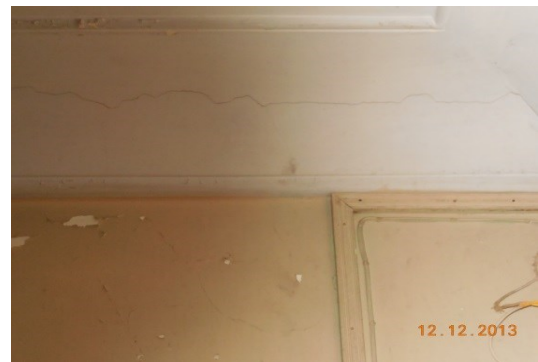
Photo 9

Inclined Crack on Wall 2 & Roof of Room No.3 of H.NO.481, First Floor, Approx. Width=0.50mm, Approx.Length=2.30m. Distance from Wall No.2=0m, Height from Floor=2.0m.

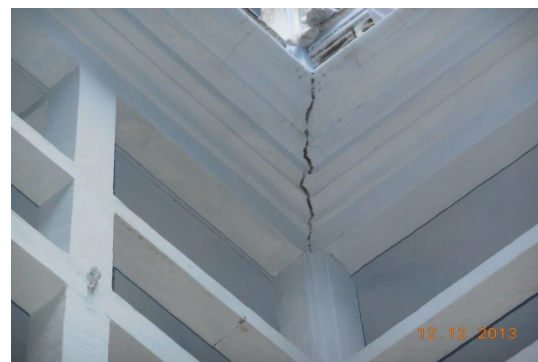
Photo 11

Horizontal Crack on Roof of Balcony of H.No.481, First Floor, Approx. Width=5.0mm, Approx.Length=0.60m. Distance from Wall No.3=0m, Height from Floor=3.3m.

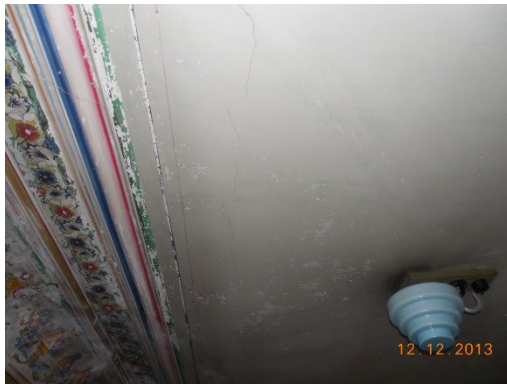
Photo 12

Inclined Crack on Roof of Hall of H.No.481, Second Floor,
Width=0.60mm, Approx.Length=3.50m.
Distance from Wall No.3=0m, Height from Floor=3.0m.

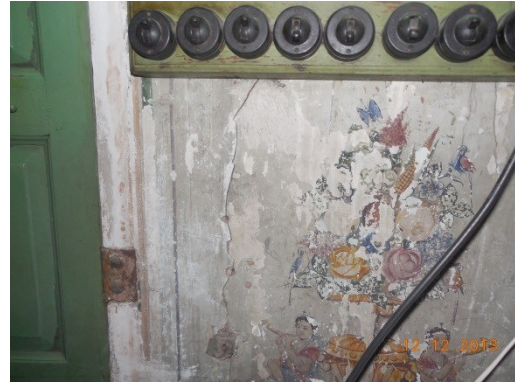
Photo 13A

Approx. Inclined Crack on Wall No.3 of Hall of H.No.481, Second Floor, Approx.
Width=1.0mm, Approx.Length=0.70m. Distance from Wall No.2=3.0m,
Height from Floor=0.60m.

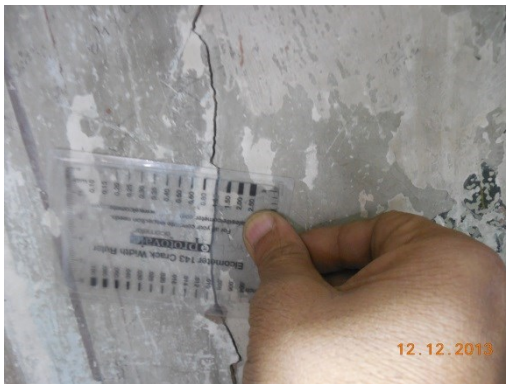
Photo 13B

Inclined Crack on Wall No.3 of Hall of H.No.481, Second Floor, Approx.
Width=1.0mm, Approx.Length=0.70m. Distance from Wall No.2=3.0m,
Height from Floor=0.60m.

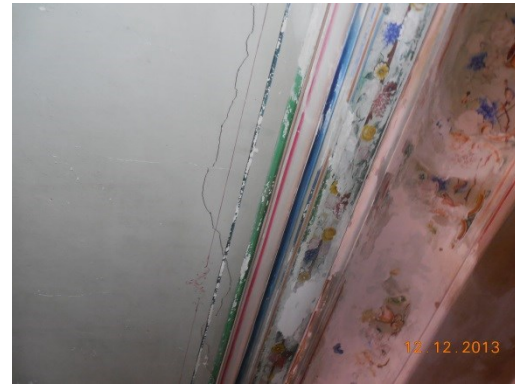
Photo 14

Inclined Crack on Wall No.3 & Roof of Hall of H.No.481, Second
Floor, Approx. Width=1.0mm, Approx.Length=4.0m. Distance from Wall
No.3=0.0m, Height from Floor=2.0m.

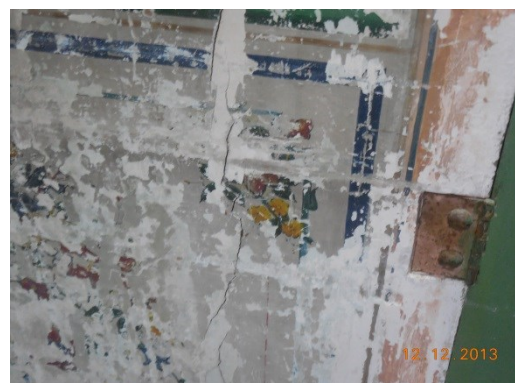
Photo 16A

Inclined Crack on Wall No.3 & Floor of Hall of H.No.481, Second
Floor, Approx. Width=1.0mm, Approx.Length=2.60m. Distance from Wall
No.1=3.0m, Height from Floor=0m.

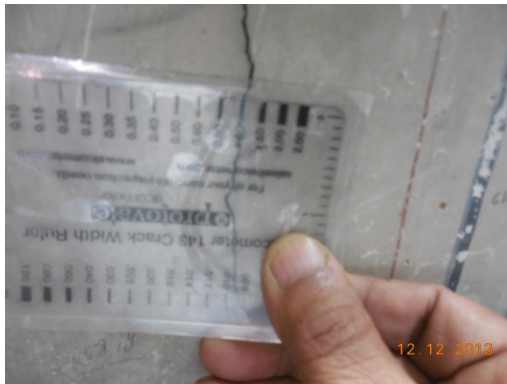
Photo 16B

Inclined Crack on Wall No.3 & Floor of Hall of H.No.481, Second Floor, Approx. Width=1.0mm, Approx.Length=2.60m. Distance from Wall No.1=3.0m, Height from Floor=0m.

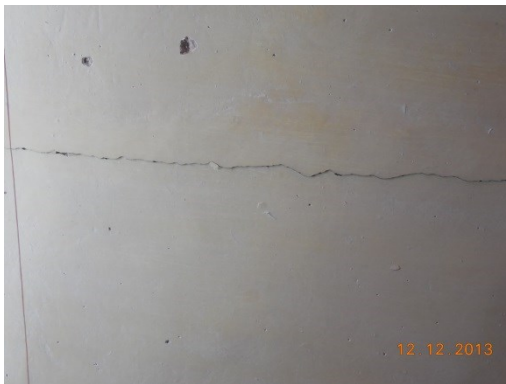
Photo 18

Horizontal Crack on Roof of Room No.2 of H.No.481, Second Floor, Approx. Width=0.6mm, Approx.Length=1.50m. Distance from Wall No.1=2.80m, Height from Floor=3.0m.

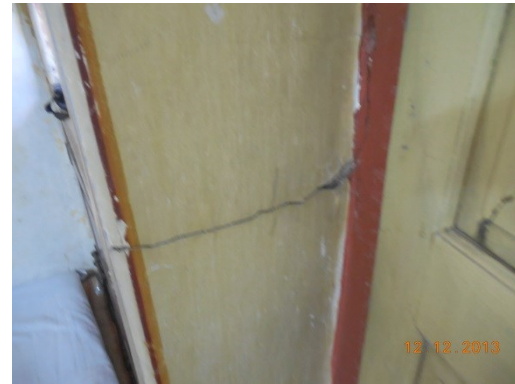
Photo 19A

Horizontal Crack on Wall No.2 of Room No.2 of H.No.481, Second Floor, Approx. Width=2.0mm, Approx.Length=0.50m. Distance from Wall No.4=1.0m, Height from Floor=1.0m.

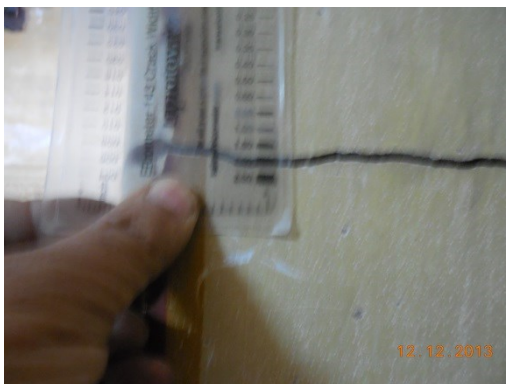
Photo 19B

Horizontal Crack on Wall No.2 of Room No.2 of H.No.481, Second Floor, Approx. Width=2.0mm, Approx.Length=0.50m. Distance from Wall No.4=1.0m, Height from Floor=1.0m.

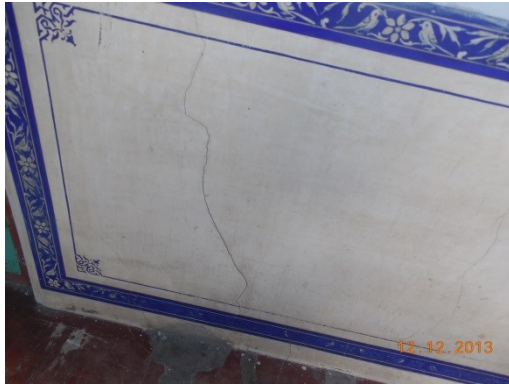
Photo 21A

Inclined Crack on Wall No.2 of Skyopen Area of H.No.481, Second Floor, Approx. Width=1.0mm, Approx.Length=1.0m. Distance from Wall No.3=3.0m, Height from Floor=2.0m.

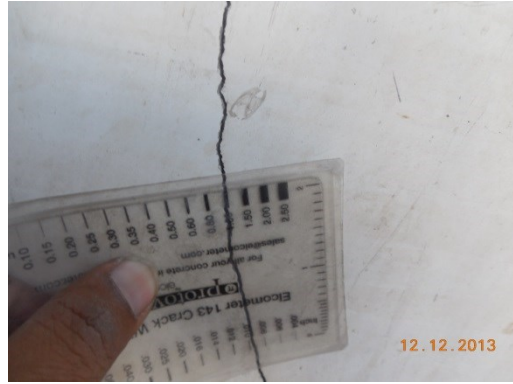
Photo 21B

Inclined Crack on Wall No.2 of Skyopen Area of H.No.481, Second Floor, Approx. Width=1.0mm, Approx.Length=1.0m. Distance from Wall No.3=3.0m, Height from Floor=2.0m.

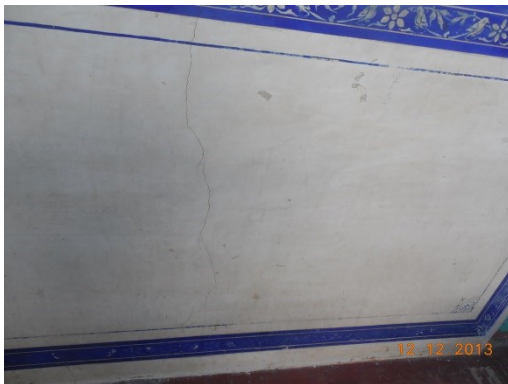
Photo 22A

Inclined Crack on Wall No.2 of Skyopen Area of H.No.481, Second Floor, Approx. Width=0.30mm, Approx.Length=1.0m. Distance from Wall No.3=2.60m, Height from Floor=0m.

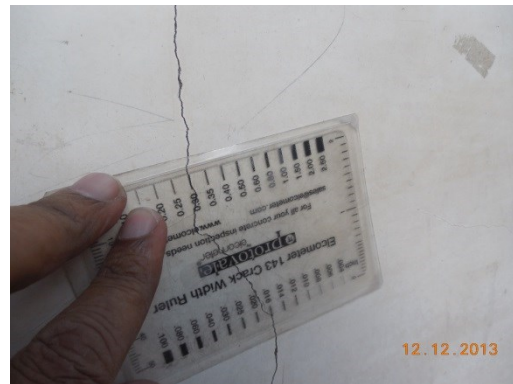
Photo 22B

Inclined Crack on Wall No.2 of Skyopen Area of H.No.481, Second Floor, Approx. Width=0.30mm, Approx.Length=1.0m. Distance from Wall No.3=2.60m, Height from Floor=0m.

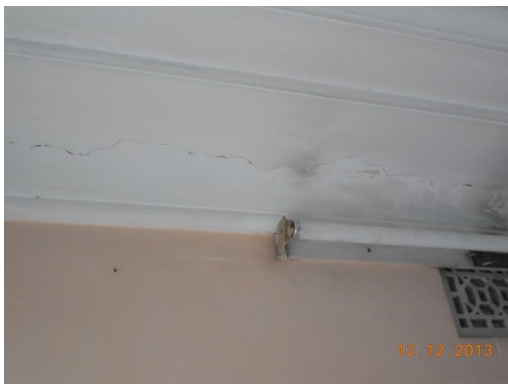
Photo 23

Inclined Crack on Roof of Hall No.2 of H.No.481, Second Floor, Approx. Width=0.8mm, Approx.Length=3.0m. Distance from Wall No.4=0.0m, Height from Floor=3.0m.

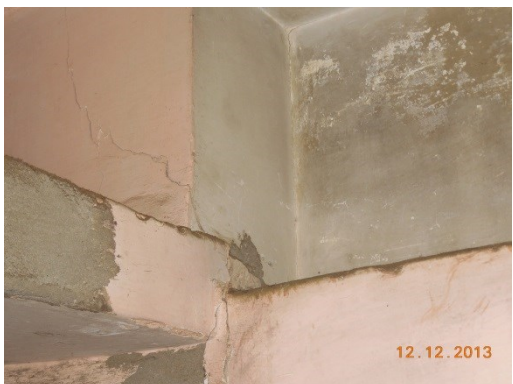
Photo 24

Inclined Crack on Wall No.4 of Kitchen of H.No.481, Second Floor, Approx. Width=0.6mm, Approx.Length=0.50m. Distance from Wall No.1=0.40m, Height from Floor=2.10m.

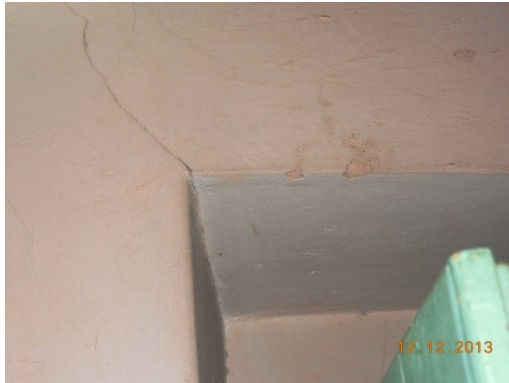
Photo 25

Inclined Crack on Wall No.3 of Kitchen of H.No.481, Second Floor, Approx. Width=0.8mm, Approx.Length=0.60m. Distance from Wall No.1=1.30m, Height from Floor=2.20m.

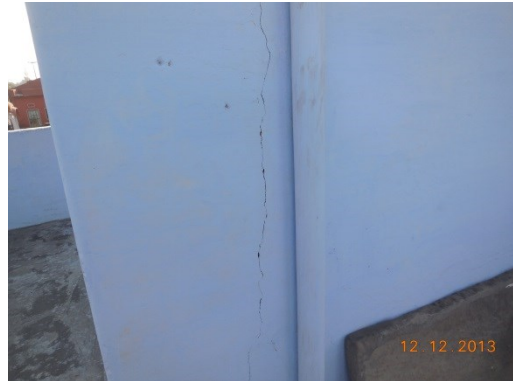
Photo 26A

Inclined Crack on Outerwall No.3 of Room No.1 of H.No.481, Terrace, Approx. Width=1.5mm, Approx.Length=2.20m. Distance from Wall No.1=0.10m, Height from Floor=0m.

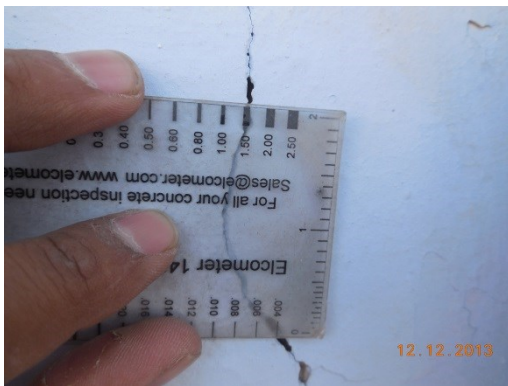
Photo 26B

Inclined Crack on Outerwall No.3 of Room No.1 of H.No.481, Terrace, Approx. Width=1.5mm, Approx.Length=2.20m. Distance from Wall No.1=0.10m, Height from Floor=0m.

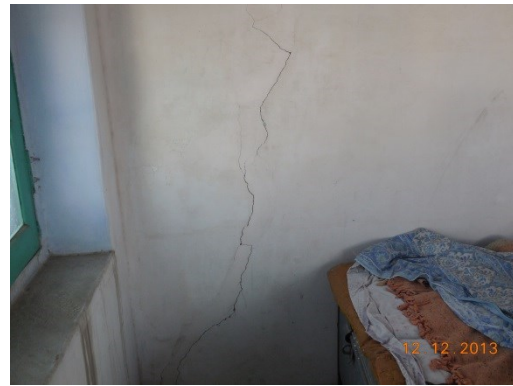
Photo 27A

Inclined Crack on Wall No.4 of Room No.1 of H.No.481, Terrace, Approx. Width=1.0mm, Approx.Length=2.30m. Distance from Wall No.1=0.10m, Height from Floor=0m.

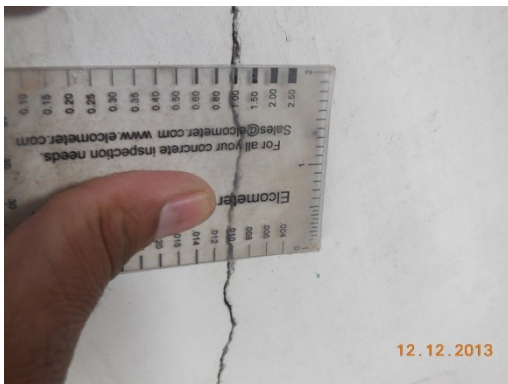
Photo 27B

Inclined Crack on Wall No.4 of Room No.1 of H.No.481, Terrace, Approx. Width=1.0mm, Approx.Length=2.30m. Distance from Wall No.1=0.10m, Height from Floor=0m.

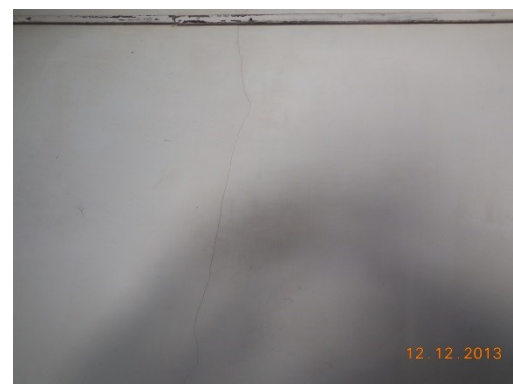
Photo 28A

Vertical Crack on Wall No.4 of Room No.1 of H.No.481, Terrace, Approx. Width=0.25mm, Approx.Length=1.30m. Distance from Wall No.1=2.60m, Height from Floor=1.0m.

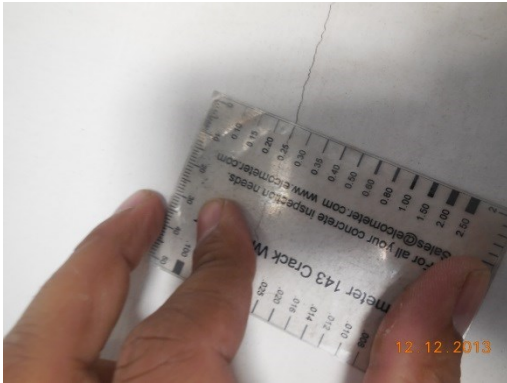
Photo 28B

Vertical Crack on Wall No.4 of Room No.1 of H.No.481, Terrace,
Approx. Width=0.25mm, Approx.Length=1.30m. Distance from Wall
No.1=2.60m, Height from Floor=1.0m.

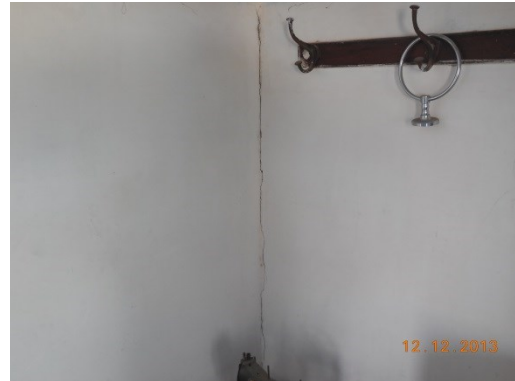
Photo 29A

Vertical Crack on Wall No.4 & 2 of Room No.2 of H.No.481, Terrace,
Approx. Width=1.50mm, Approx.Length=2.40m. Distance from Wall
No.4=0m, Height from Floor=0m.

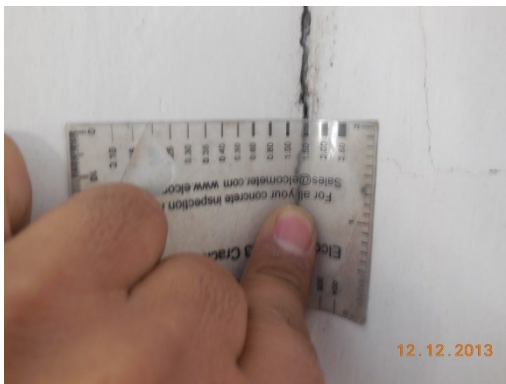
Photo 29B

Vertical Crack on Wall No.4 & 2 of Room No.2 of H.No.481, Terrace,
Approx. Width=1.50mm, Approx.Length=2.40m. Distance from Wall
No.4=0m, Height from Floor=0m.

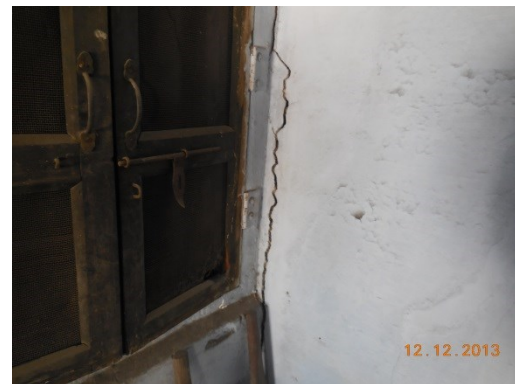
Photo 30

Vertical Crack on Wall No.4 & 1 of Room No.2 of H.No.481, Terrace,
Approx. Width=5.0mm, Approx.Length=1.80m. Distance from Wall
No.4=0m, Height from Floor=0m.

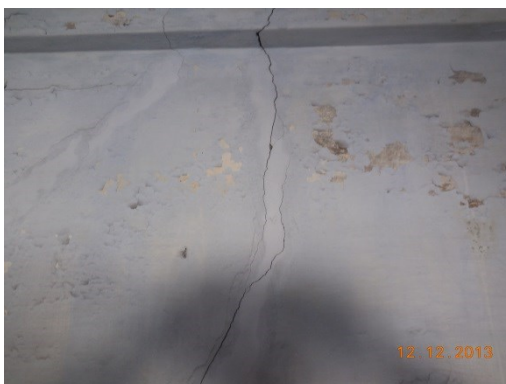
Photo 31A

Inclined Crack on Wall No.4 of Room No.2 of H.No.481, Terrace,
Approx. Width=0.8mm, Approx.Length=1.60m. Distance from Wall
No.1=0.30m, Height from Floor=1.0m.

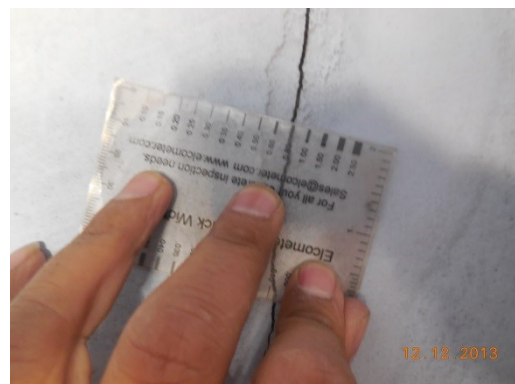
Photo 31B

Inclined Crack on Wall No.4 of Room No.2 of H.No.481, Terrace,
Approx. Width=0.8mm, Approx.Length=1.60m. Distance from Wall
No.1=0.30m, Height from Floor=1.0m.

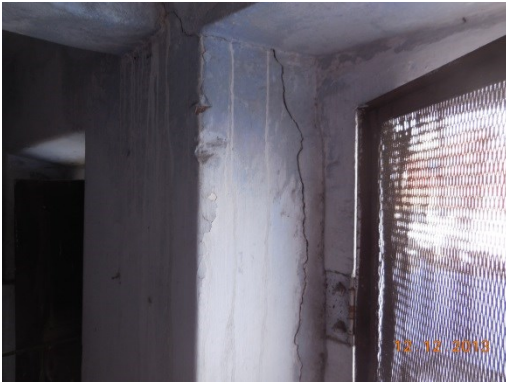
Photo 32A

Inclined Crack on Wall No.3 of Room No.2 of H.No.481, Terrace, Approx. Width=1.50mm, Approx.Length=0.60m. Distance from Wall No.1=1.20m, Height from Floor=1.50m.

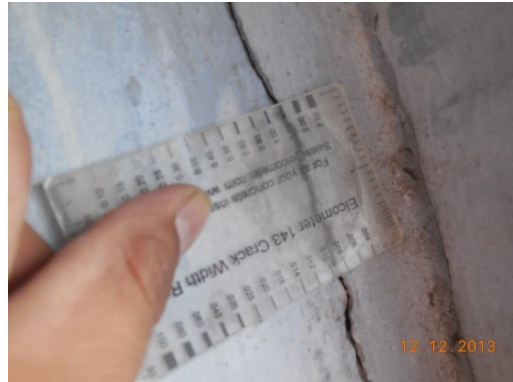
Photo 32B

Inclined Crack on Wall No.3 of Room No.2 of H.No.481, Terrace, Approx. Width=1.50mm, Approx.Length=0.60m. Distance from Wall No.1=1.20m, Height from Floor=1.50m.

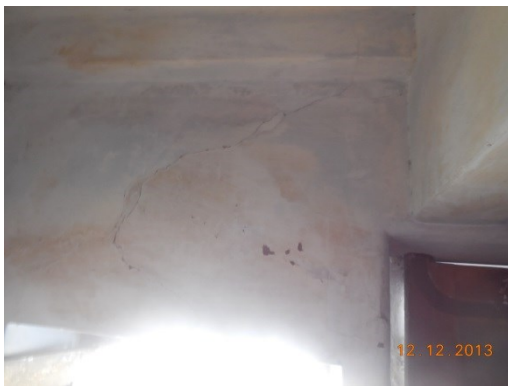
Photo 33A

Inclined Crack on Wall No.3 of Room No.3 of H.No.481, Terrace, Approx. Width=0.40mm, Approx.Length=0.45m. Distance from Wall No.2=0.30m, Height from Floor=1.70m.

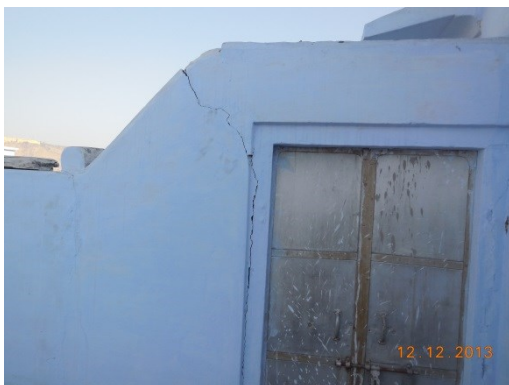
Photo 34A

Vertical Crack on Wall No.2 of Open Area of H.No.481, Terrace, Approx. Width=1.50mm, Approx.Length=2.10m. Distance from Wall No.3=1.0m, Height from Floor=0m.

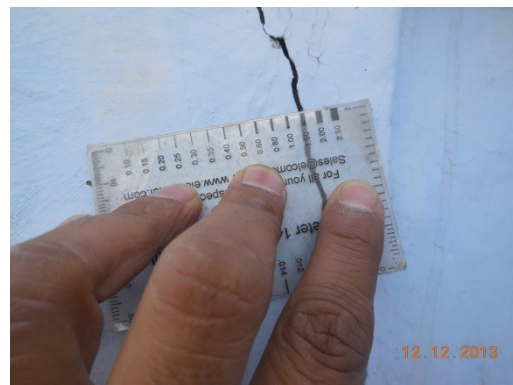
Photo 34B

Vertical Crack on Wall No.2 of Open Area of H.No.481, Terrace, Approx. Width=1.50mm, Approx.Length=2.10m. Distance from Wall No.3=1.0m, Height from Floor=0m.

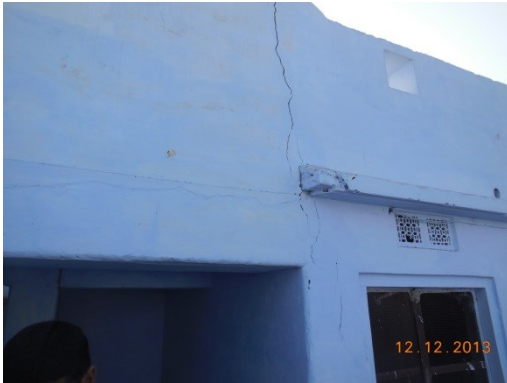
Photo 35A

Vertical Crack on Wall No.3 of Open Area of H.No.481, Terrace, Approx. Width=3.0mm, Approx.Length=1.60m. Distance from Wall No.1=2.0m, Height from Floor=1.60m.

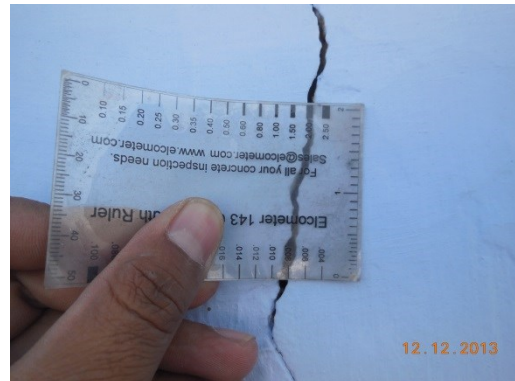
Photo 35B

Vertical Crack on Wall No.3 of Open Area of H.No.481, Terrace, Approx. Width=3.0mm, Approx.Length=1.60m. Distance from Wall No.1=2.0m, Height from Floor=1.60m.

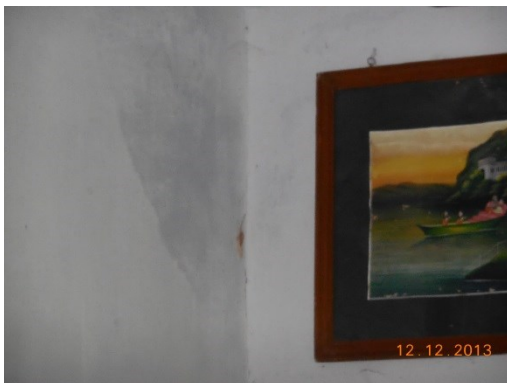
Photo 36

Seepage on Wall No.1 & 4 of Hall of H.No.481,Ground Floor

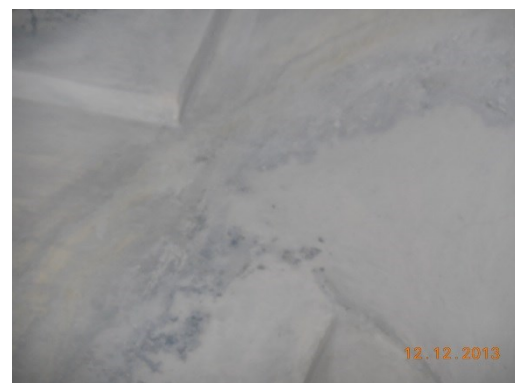
Photo 37

Seepage on Wall No.3 & 2 of Hall of H.No.481,Ground Floor

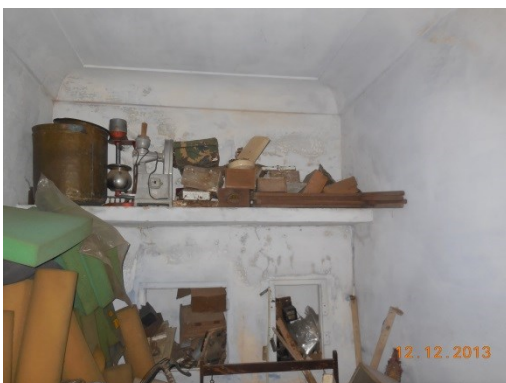
Photo 38

Seepage on Wall No.4 & 2 of Room 1 of H.No.481,Ground Floor

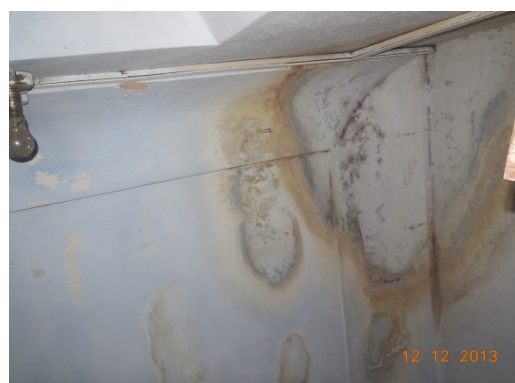
Photo 39

Seepage on Roof of Room 1 of H.No.481,Ground Floor

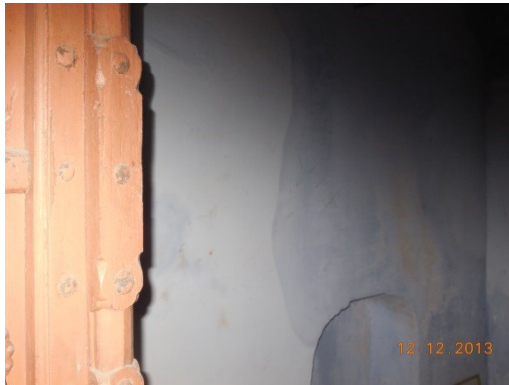
Photo 40

Seepage on Wall No.2 of Room No.2 of H.No.481,Ground Floor

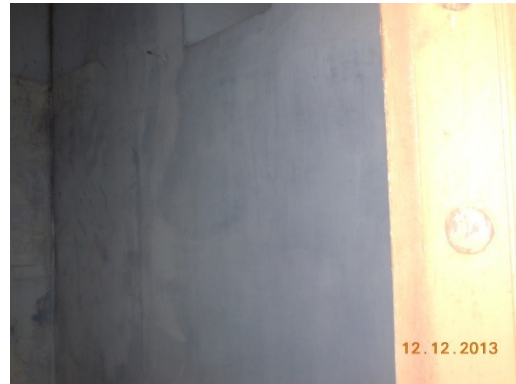
Photo 41

Seepage on Wall No.1 of Room No.2 of H.No.481,Ground Floor

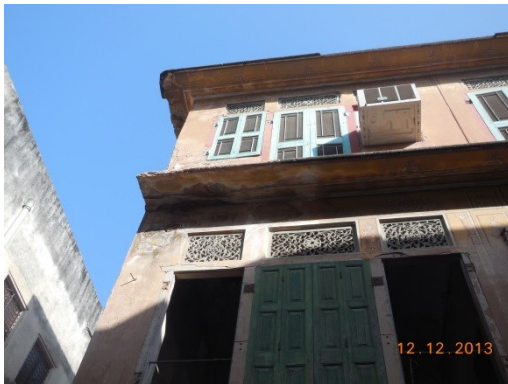
Photo 42

Damage on Outerwall of Backside of H.No.481,Ground Floor

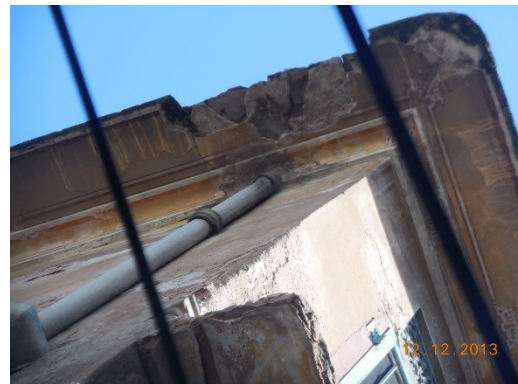
Photo 43

Damage on Roof Shade of Backside of H.No.481,Ground Floor

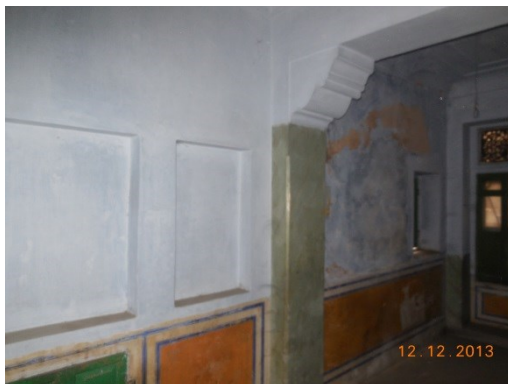
Photo 44

Seepage on Wall No.4 of Room 1 of H.No.481,First Floor

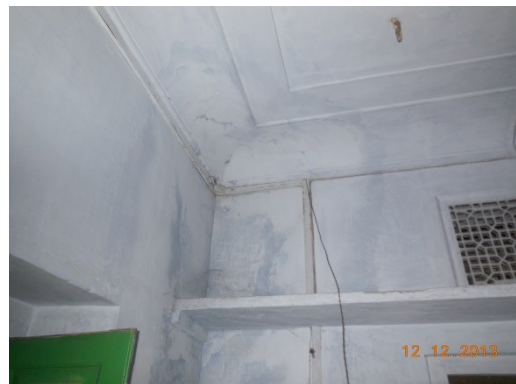
Photo 45

Seepage on Wall No.3 & 1 of Room 1 of H.No.481,First Floor

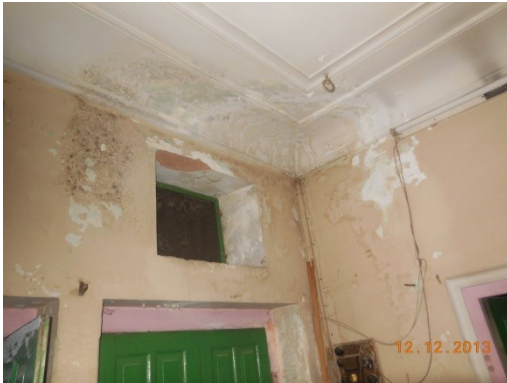
Photo 46
Plaster Removal on Roof of Room 1 of H.No.481,First Floor

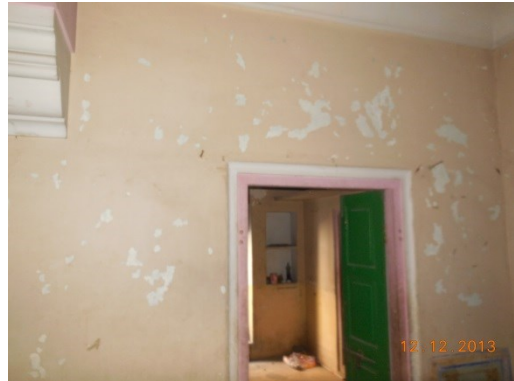
Photo 47
Plaster Removal on Wall No.2 of Room No.2 of H.No.481,First Floor

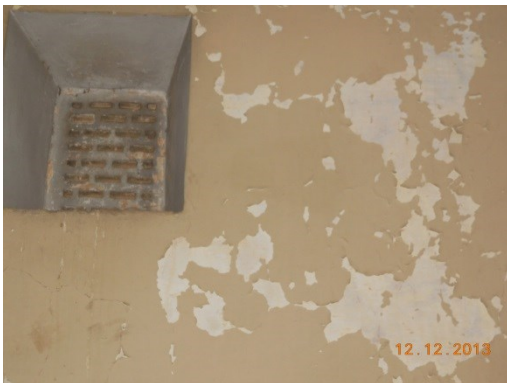
Photo 48
Peeling of Plaster on Wall No.4 of Room No.3 of H.No.481, First Floor

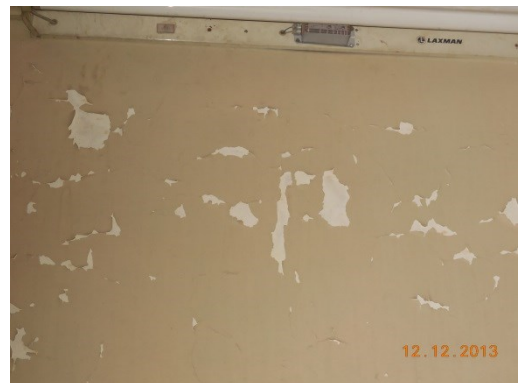
Photo 49
Peeling of Plaster on Wall No.3 of Room No.3 of H.No.481,First Floor

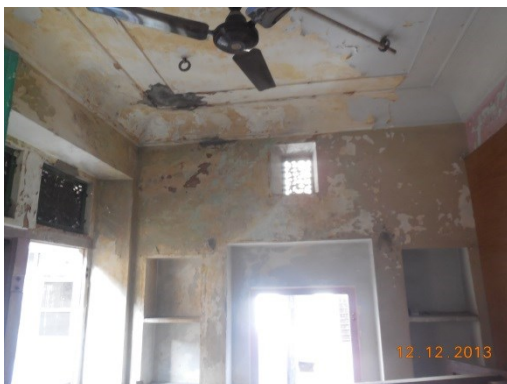
Photo 50
Seepage on Wall No.4,1 & Roof of Room 3 of H.No.481,First Floor

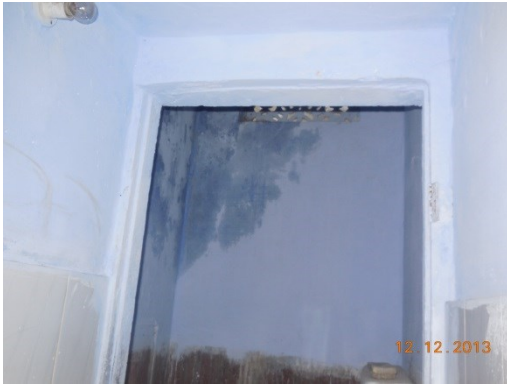
Photo 52

Seepage on Wall No.4 of Lobby of H.No.481, First Floor

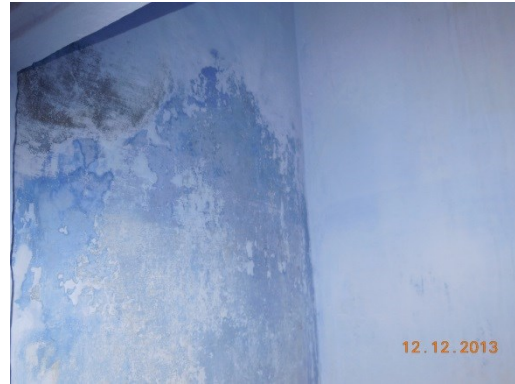
Photo 53

Seepage on Wall No.4 of Toilet & Bath No.2 of H.No.481, First Floor

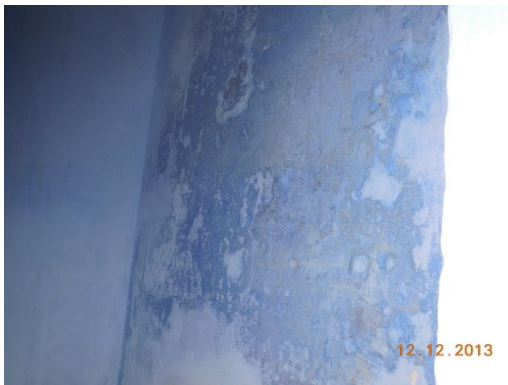
Photo 54

Seepage on Wall No.3 of Toilet & Bath No.2 of H.No.481, First Floor

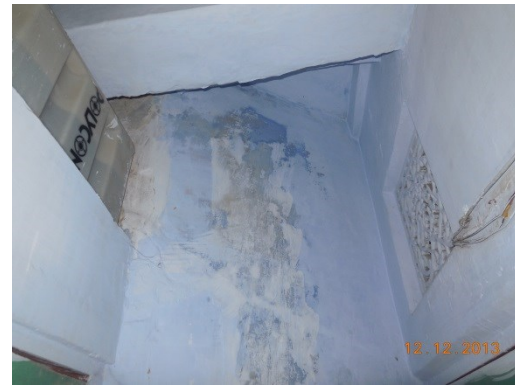
Photo 55

Seepage on Wall No.5 of Passage of Toilet & Bath No.2, First Floor

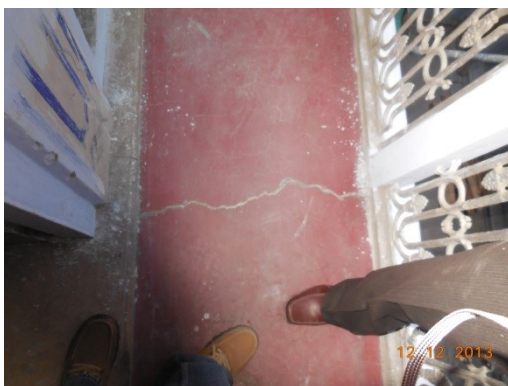
Photo 56

Damage on Floor of Open Sky Balcony of H.No.481, First Floor

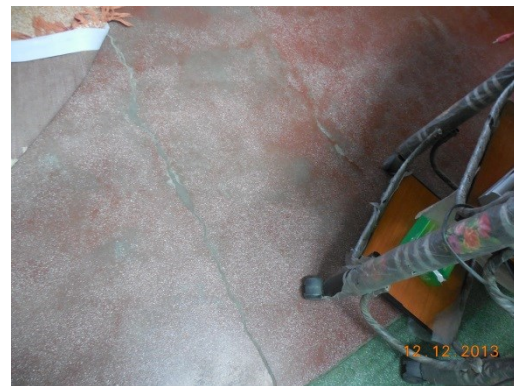
Photo 57

Plaster Crack on Floor of Hall of H.No.481, Second Floor

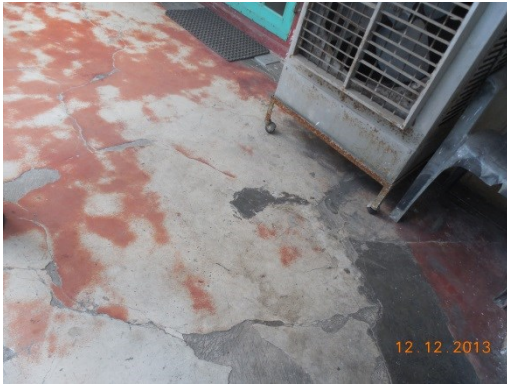
Photo 58

Plaster Crack on Floor of Varandah of H.No.481, Second Floor

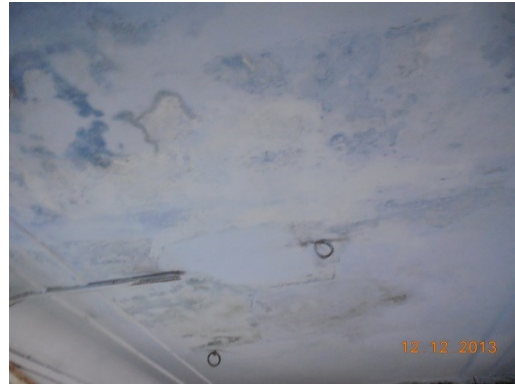
Photo 59

Seepage on Roof of Room No.3 of H.No.481, Second Floor

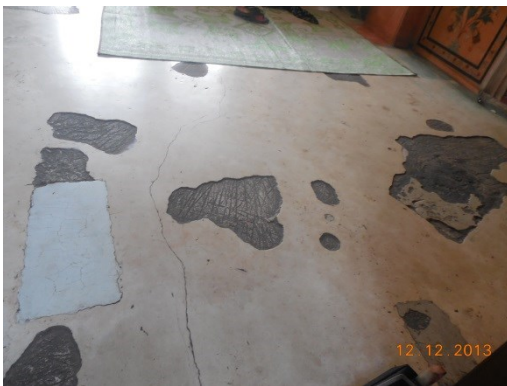
Photo 60

Plaster Crack on Floor of Hall No.2 of H.No.481, Second Floor
