Pre Building Condition Survey Report

Name and Address of Structure :	Choti Chopar to Badi Chopar (Down Line)
---------------------------------	---

Name of the Project	Contract JMRC-UG1B “Design and Construction of Tunnel between Chandpole and Badi Chouper and reverse line by Shield TBM, Underground Metro Stations at Choti Chouper and Badi Chouper by Cut and Cover Methods on East West Corridor of Jaipur Metro Rail Corporation Limited .”	
Owner :

Pre Building Condition Survey Report Choti Chopar to Badi Chopar (Down Line)

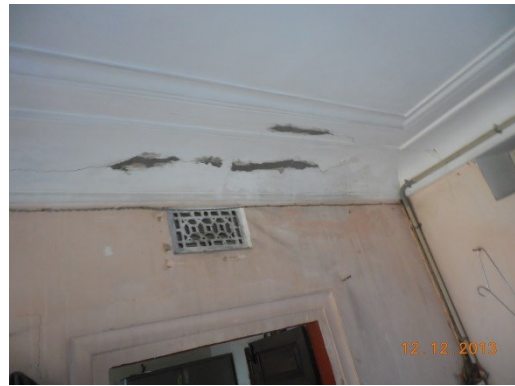
Photo 61

Plaster Removal on Roof of Hall No.2 of H.No.481, Second Floor

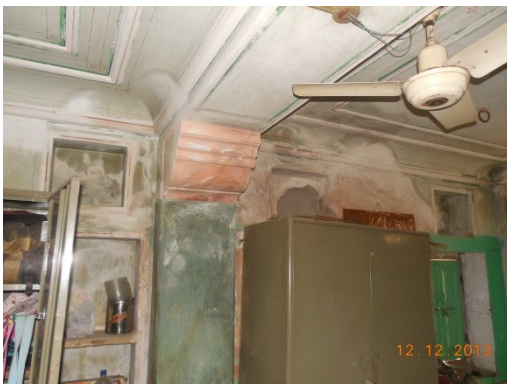
Photo 62

Seepage on Wall No.4 of Room No.5 of H.No.481, Second Floor

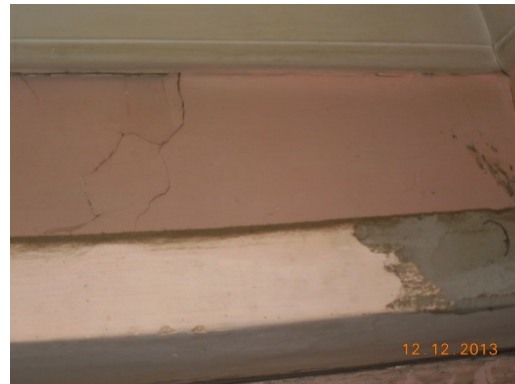
Photo 63

Plaster Removal on Wall No.1 of Kitchen of H.No.481, Second Floor

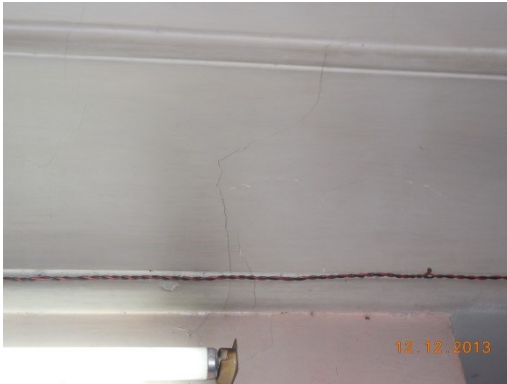
Photo 64

Plaster Crack on Roof of Kitchen of H.No.481, Second Floor

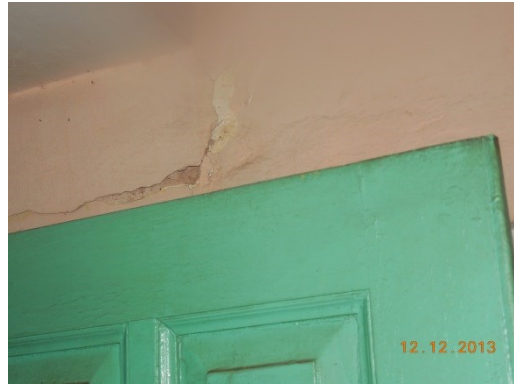
Photo 65

Plaster Removal on Wall No.1 of Kitchen of H.No.481, Second Floor

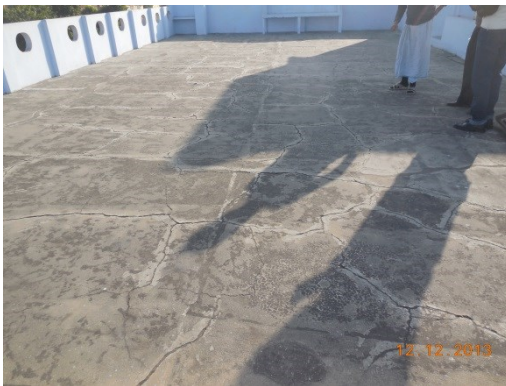
Photo 66

Plaster Crack on Floor of Terrace of H.No.481, Terrace

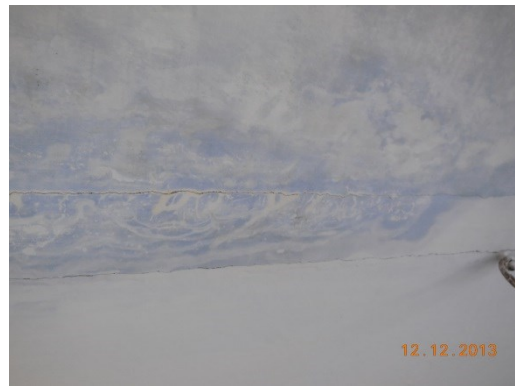
Photo 67

Seepage on Roof of Room No.1 of H.No.481, Terrace

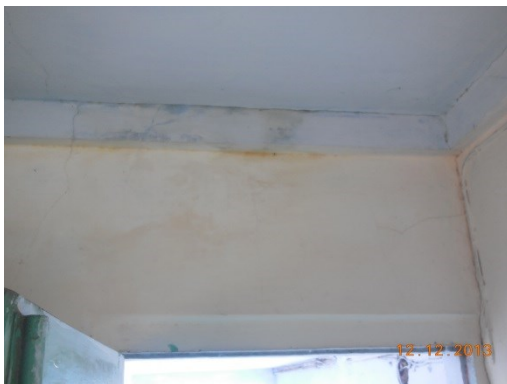
Photo 68

Seepage on Wall No.4 of Room No.1 of H.No.481, Terrace

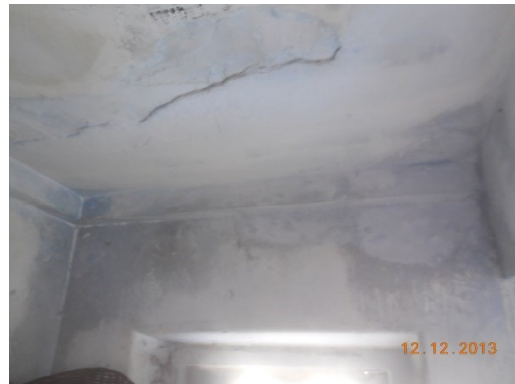
Photo 69

Seepage on Wall No.3 & 2 of Room No.1 of H.No.481, Terrace

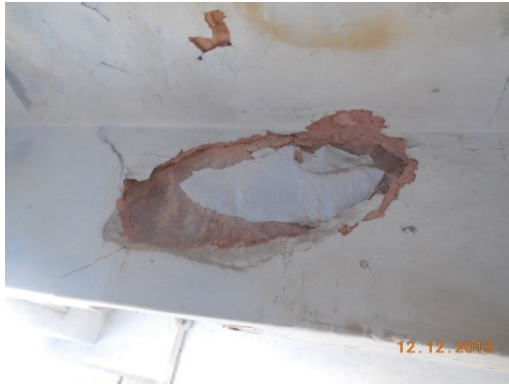
Photo 70

Plaster Removal on Roof Beam of Room No.2 of H.No.481, Terrace

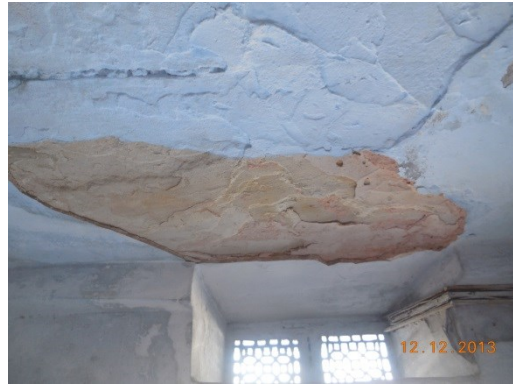
Photo 71

Plaster Removal on Roof of Room No.2 of H.No.481, Terrace

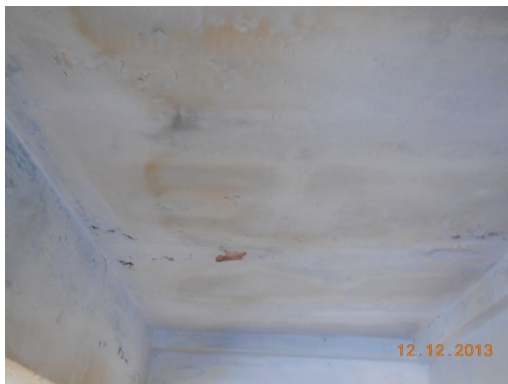
Photo 72

Seepage on Roof of Room No.2 of H.No.481, Terrace

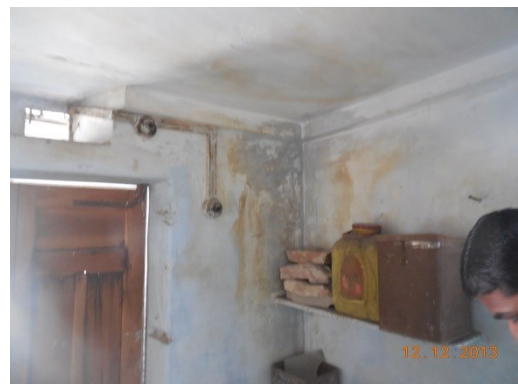
Photo 73

Seepage on Wall No.3 & 1 of Room No.3 of H.No.481, Terrace

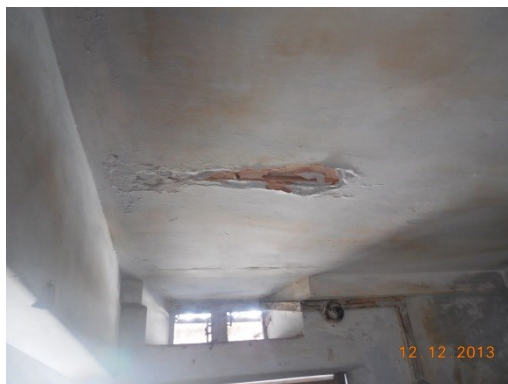
Photo 74

Plaster Removal on Roof of Room No.3 of H.No.481, Terrace

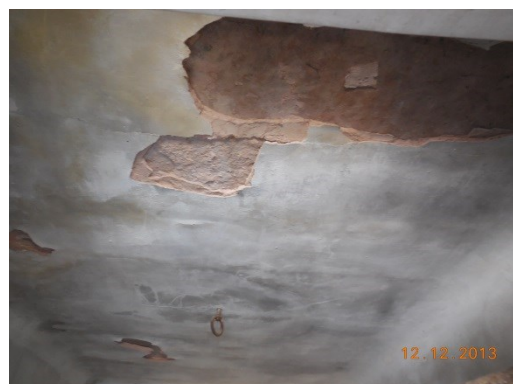
Photo 75

Plaster Removal on Roof of Room No.5 of H.No.481, Terrace

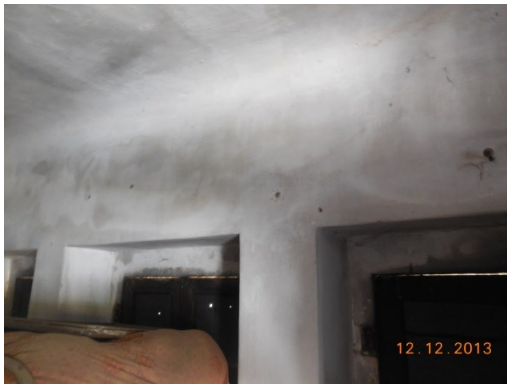
Photo 76

Seepage on Wall No.2 of Room No.5 of H.No.481, Terrace

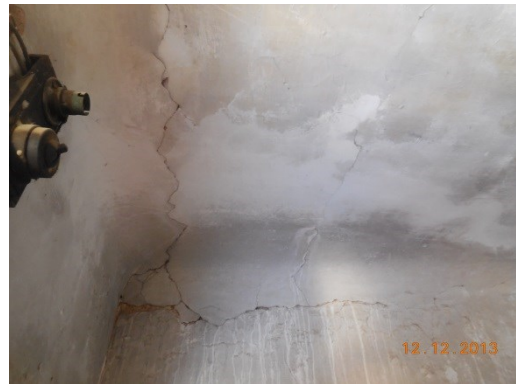
Photo 77

Plaster Crack on Wall No.1 of Room No.5 of H.No.481, Terrace

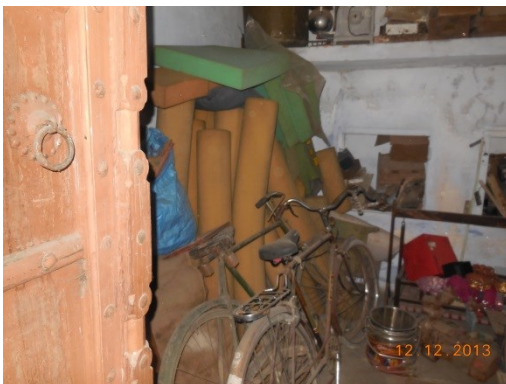
Photo 78

Covered With Wooden, Wall No.1 of Room No.1 of H.No.481, Ground Floor

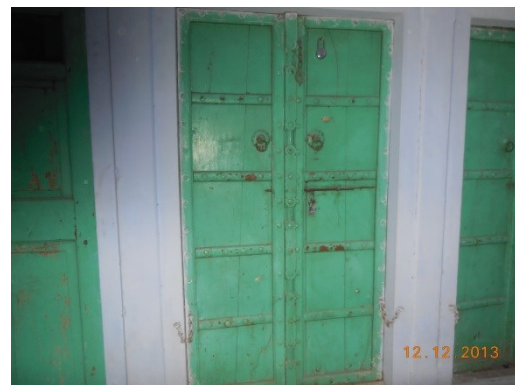
Photo 79

Locked, Balanced Portion of H.No.481, Ground Floor

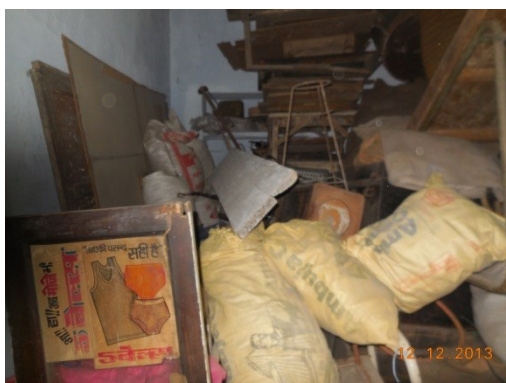
Photo 80

Covered With Material, All Walls of Store No.2 of H.No.481, Ground Floor

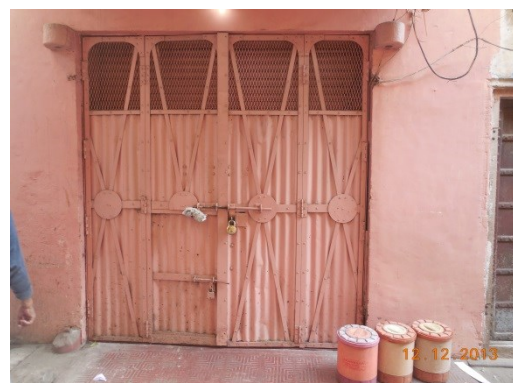
Photo 81

Locked, Garrage No.1 of H.No.481, Ground Floor

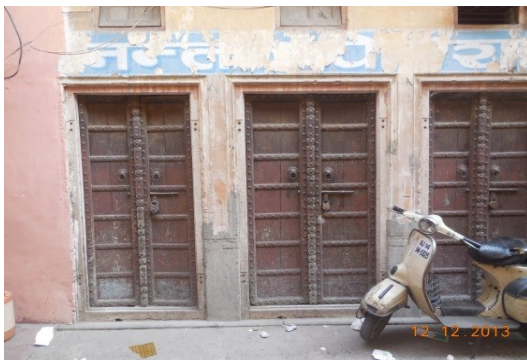
Photo 82
Locked, Hall No.2 of H.No.481, Ground Floor

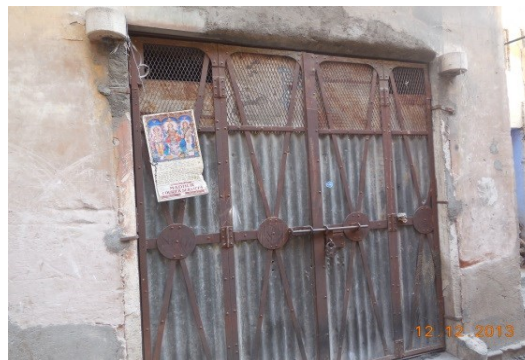
Photo 83
Locked, Garrage No.2 of H.No.481, Ground Floor

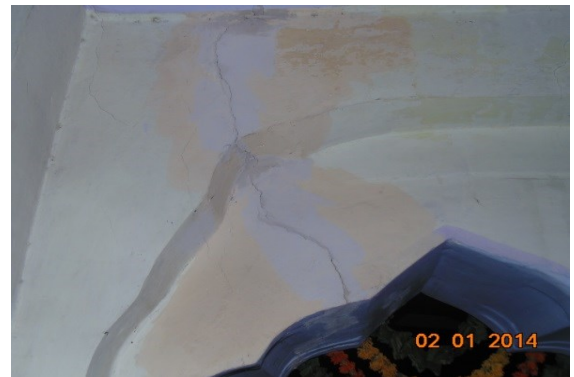
Photo 4
Inclined Crack on Wall No.3 of Varandah No.1 of Temple, First Floor,
Approx. Width=0.60mm, Approx.Length= 1.50m. Distance
from Wall No.2=1.20m, Height from Floor= 2.0m.

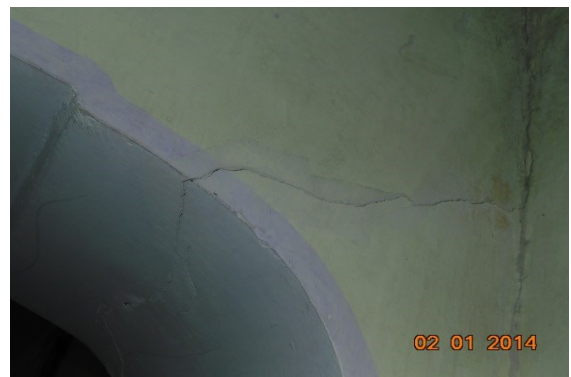
Photo 6
Inclined Crack on Wall No.4 of Varandah No.1 of Temple, First Floor,
Approx. Width=1.0mm, Approx.Length= 1.0m. Distance
from Wall No.2=0m, Height from Floor= 2.0m.

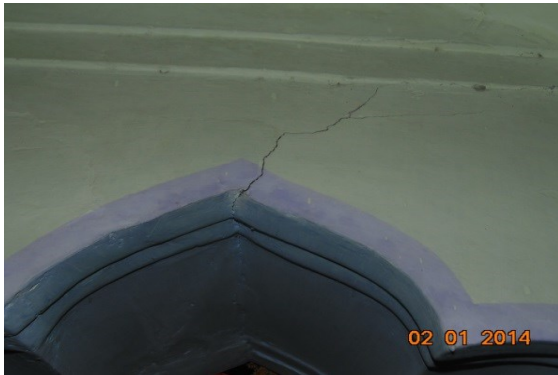
Photo 7

Inclined Crack on Wall No.3 of Varandah No.1 of Temple, First Floor,
Approx. Width=1.0mm, Approx.Length= 0.80m. Distance
from Wall No.1=1.50m, Height from Floor= 2.0m.

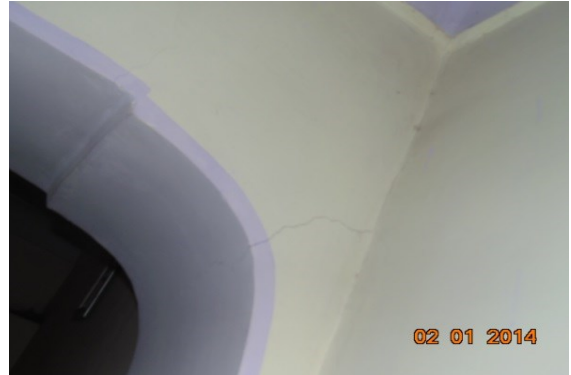
Photo 8

Inclined Crack on Wall No.3 of Varandah No.2 of Temple, First Floor,
Approx. Width=1.0mm, Approx.Length= 0.50m. Distance
from Wall No.1=0m, Height from Floor= 1.80m.

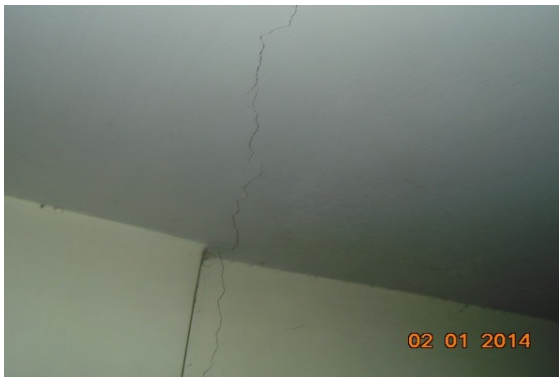
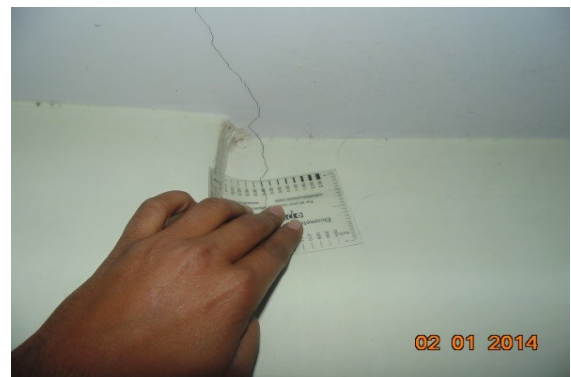
Photo 9A

Inclined Crack on Wall No.1 & Roof of Passage No.1 of Temple, First
Floor, Approx. Width=0.40mm, Approx.Length= 1.0m.
Distance from Wall No.3=0m, Height from Floor= 1.50m.

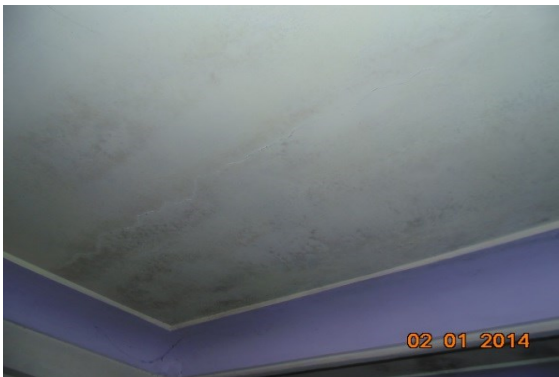
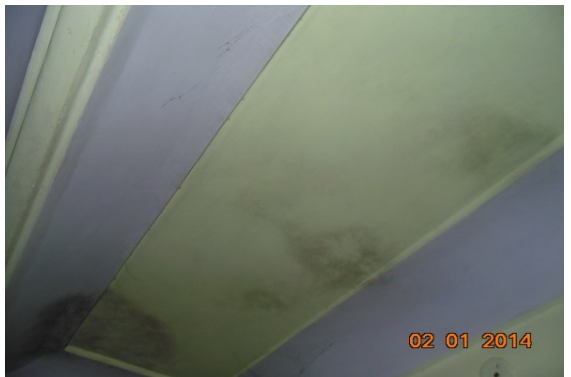
Photo 10A

Dampness/Seepage on Roof of Varandah No.1 of Temple, (F.F.)

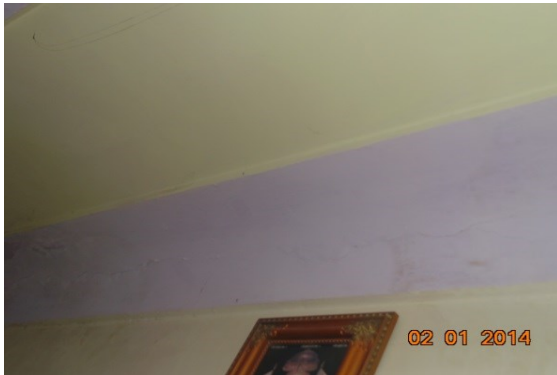
Photo 11

Plaster Crack on Roof of Varandah No.1 of Temple, (F.F.)

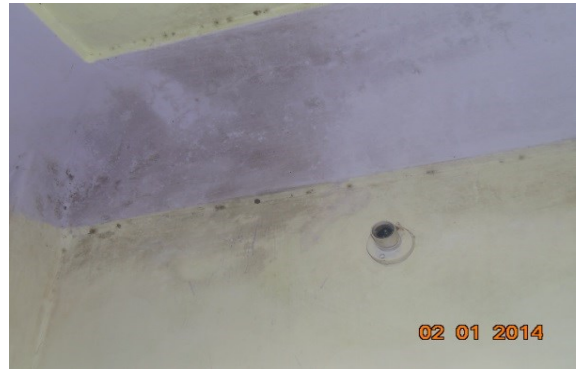
Photo 12

Dampness/Seepage on Wall No.3 & Roof of Varandah No.2 of Temple, (F.F.)

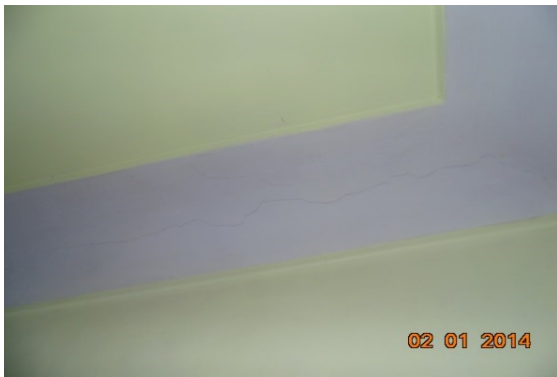
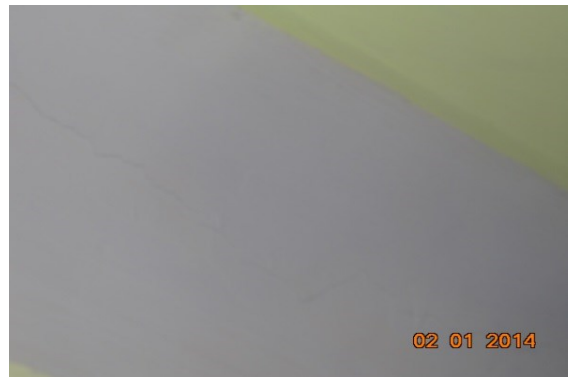
Photo 13A

Plaster Crack on Roof of Varandah No.2 of Temple, (F.F.)

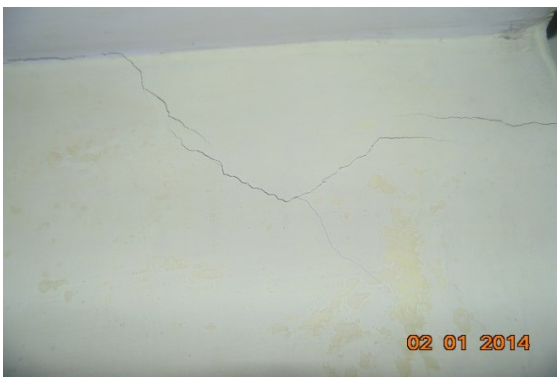
Photo 14A

Plaster Crack on Wall No.2 of Passage No.1 of Temple, (F.F.)

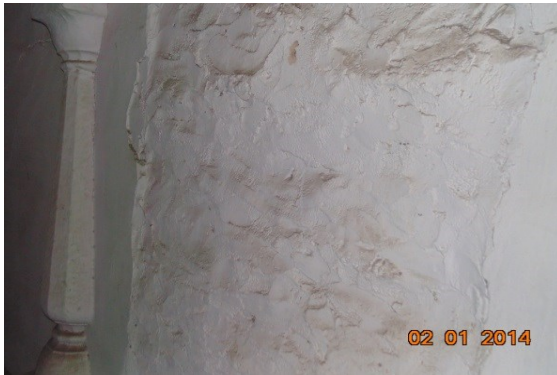
Photo 15

Plaster Removal on Wall No.2 of Passage No.2 of Temple, (F.F.)

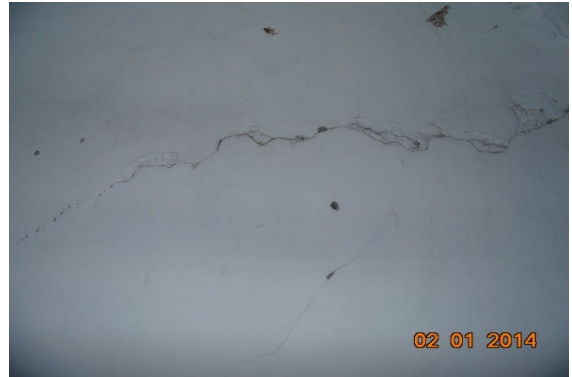
Photo 16

Plaster Crack on Wall No.2 of Passage No.2 of Temple, (F.F.)

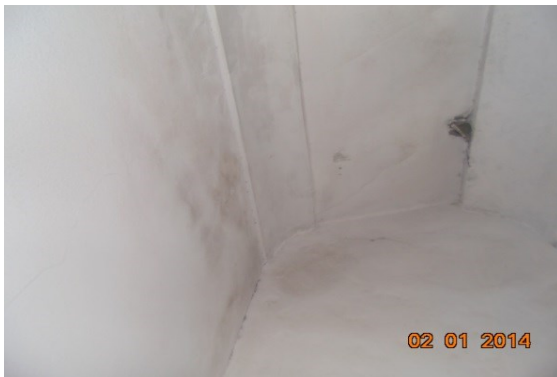
Photo 17

Dampness/Seepage on Roof & Wall No.1 of Passage No.2 of Temple, (F.F.)

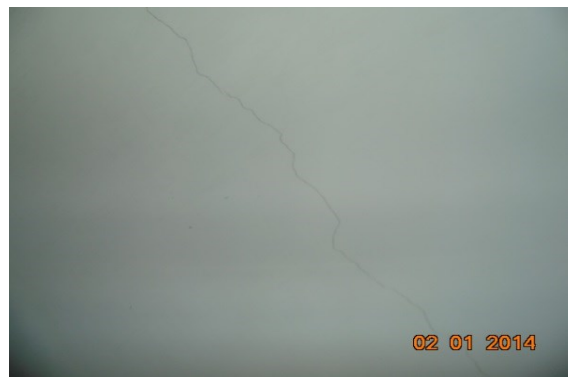
Photo 18

Plaster Crack on Roof of Passage No.3 of Temple, (F.F.)

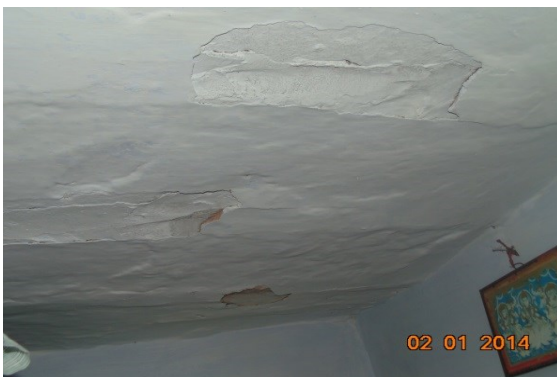
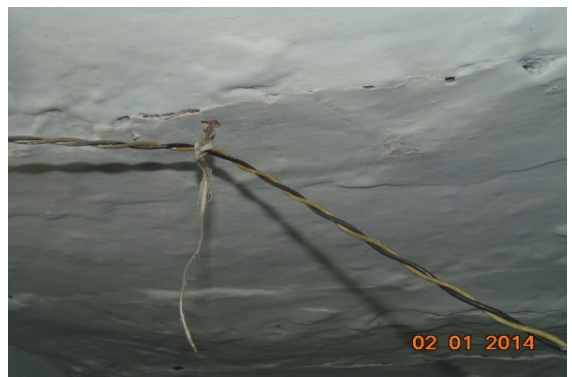
Photo 19A

Plaster Removal on Roof of Room No.1 of Temple, (F.F.)

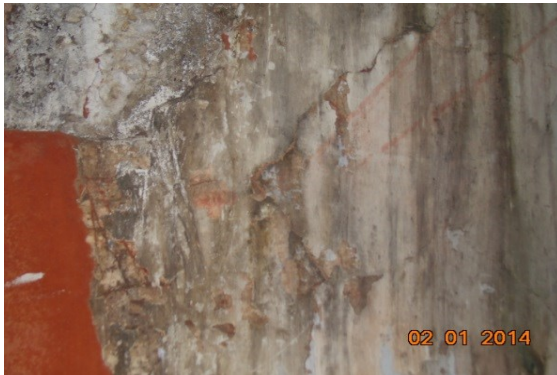
Photo 20

Plaster Crack on Wall No.1 of Varandah of Temple, (S.F.)

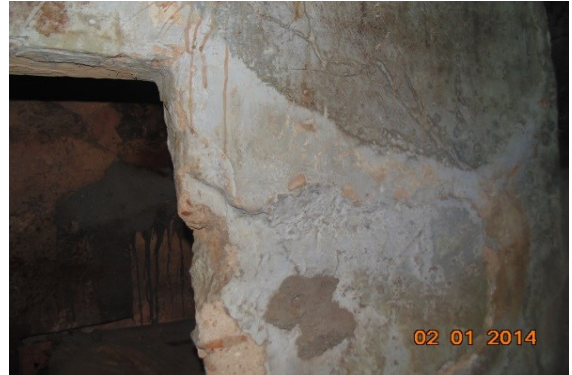
Photo 21

Plaster Removal on Wall No.1 of Staircase SF to Terrace of Temple, (S.F.)

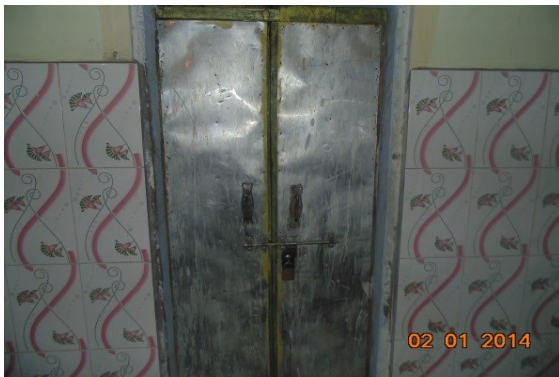
Photo 22

Locked, Room No.1, First Floor

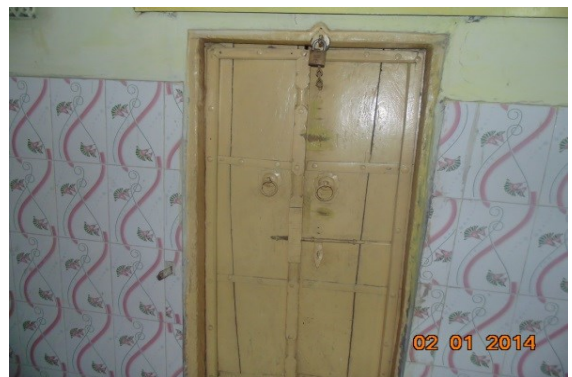
Photo 23

Locked, Room No.2, First Floor

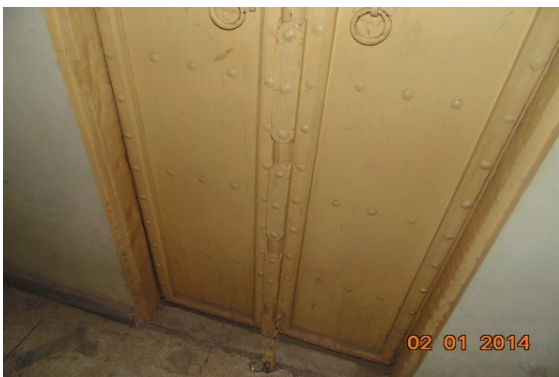
Photo 24

Locked, Room No.3, First Floor

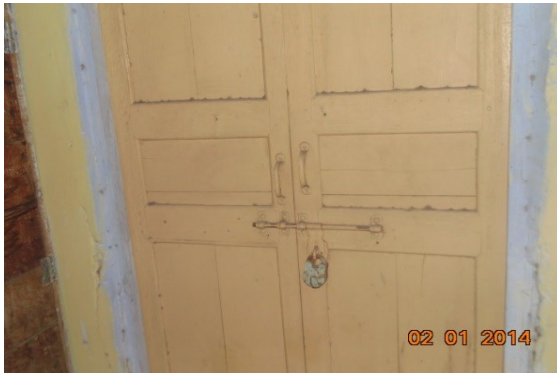
Photo 26

Locked, Room No.3, Second Floor

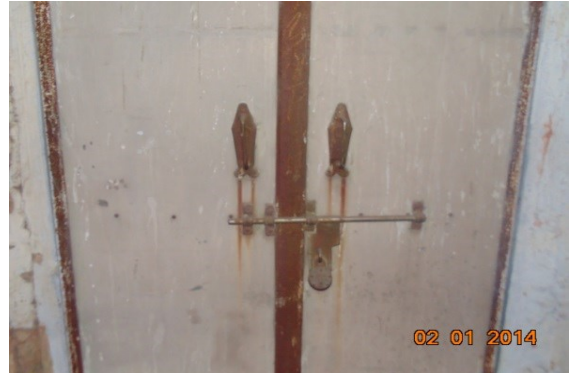
Photo 27

Locked, Store Room, Second Floor

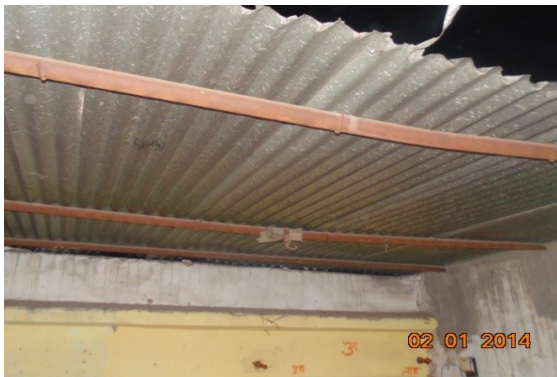
Photo 28

Teenshade, Roof of Varandah of Temple, Second Floor
