Pre Building Condition Survey Report

Name and Address of Structure :	Choti Chopar to Badi Chopar (UP Line)
---------------------------------	---------------------------------------

Name of the Project	Contract JMRC-UG1B “Design and Construction of Tunnel between Chandpole and Badi Chouper and reverse line by Shield TBM, Underground Metro Stations at Choti Chouper and Badi Chouper by Cut and Cover Methods on East West Corridor of Jaipur Metro Rail Corporation Limited .”	
Owner :

Shoping Complex - Shop No. 169-188
Tripolia Bazar
Jaipur
Unique ID: CC BC UP 0001

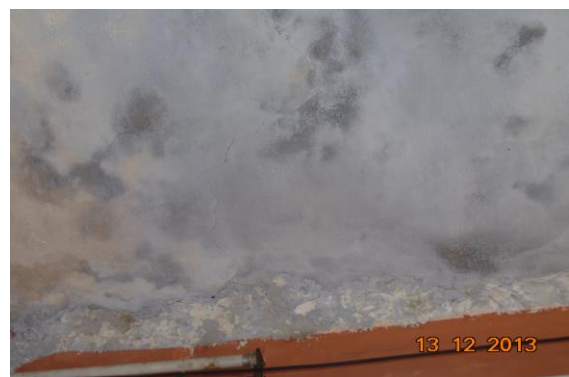
Photo 18
Inclined Crack on Roof of Varanda S.No.170A, Ground Floor
Approx. Width = 0.5mm, Approx. Length = 3m.
Height from Floor = 3m.

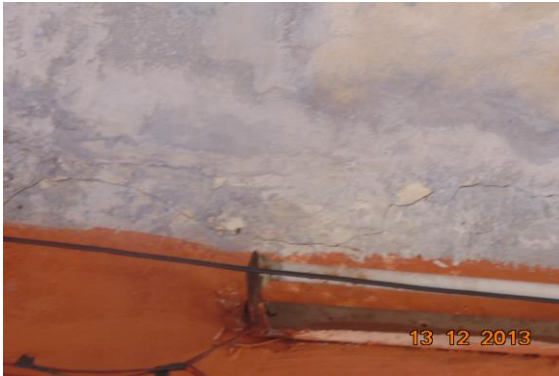
Photo 19

Inclined Crack on Roof of Varanda S.No.170B, Ground Floor Approx. Width = 1mm, Approx. Length = 1m. Distance Back Side Right Side External Column = 0m, Height Floor = 3m.

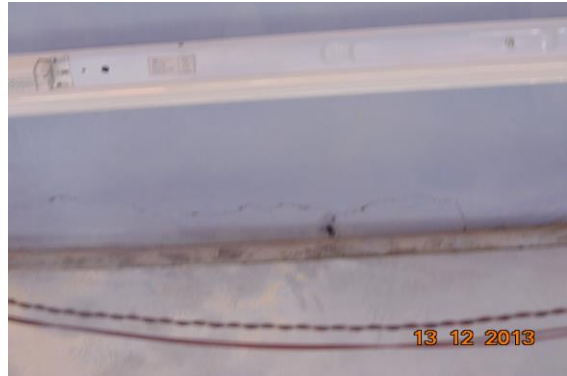
Photo 20

Horizontal Crack on Roof of Varanda, Shop No. 171, Ground Floor Approx. Width = 1mm, Approx. Length = 3m. Height from Floor = 3m.

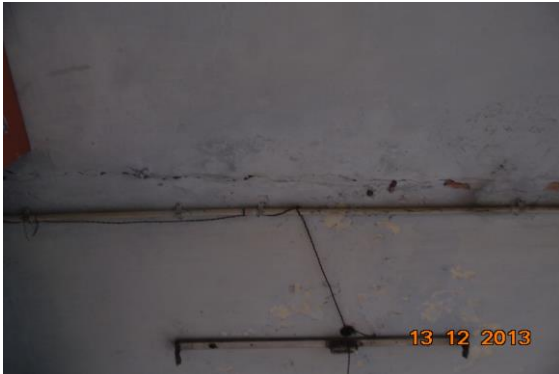
Photo 21

Horizontal Crack on Roof of Varanda, Shop No.177, Ground Floor Approx. Width = 0.8mm, Approx. Length = 3m. Distance from Back of Left Side External Column = 0m, Height from Floor = 3m.

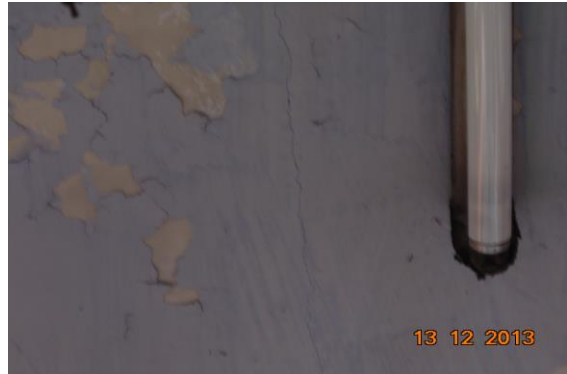
Photo 22

Horizontal Crack on Roof of Varanda, Shop No. 178, Ground Floor Approx. Width = 1.5mm, Approx. Length = 3m. Distance from External L/S Column = m, Height from Floor = 3m.

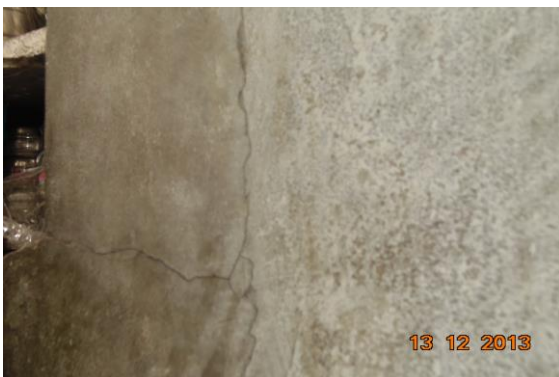
Photo 23

Inclined Crack on All Walls of Part B, Shop No. 178, Basement Approx. Width = 0.5mm, Approx. Length = 1.1m. Distance from W3 = 0.6m, Height from Floor = 1m.

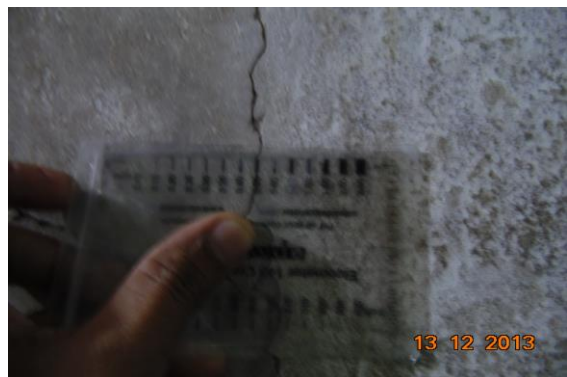
Photo 23A

Inclined Crack on All Walls of Part B, Shop No. 178, Basement Approx. Width = 0.5mm, Approx. Length = 1.1m. Distance from W3 = 0.6m, Height from Floor = 1m.

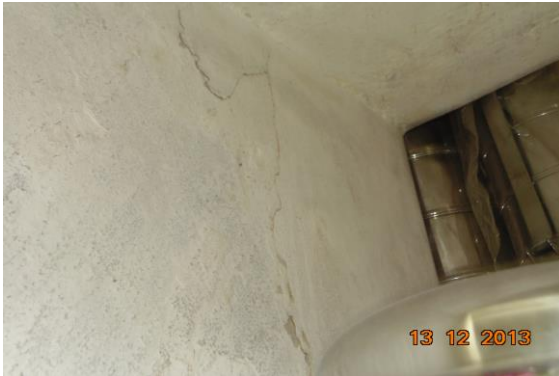
Photo 24

Inclined Crack on Shop No. 178, Basement
Approx. Width = 0.5mm, Approx. Length = 0.6m.
Distance from Door of Part B = 0m, Height from Floor = 2m.

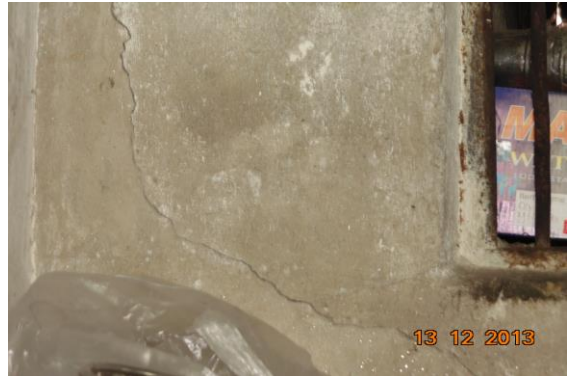
Photo 25

Inclined Crack on Part A, Shop No. 178, Basement
Approx. Width = 0.8mm, Approx. Length = 1m.
Distance from W4 = 2m, Height from Floor = 1.7m.

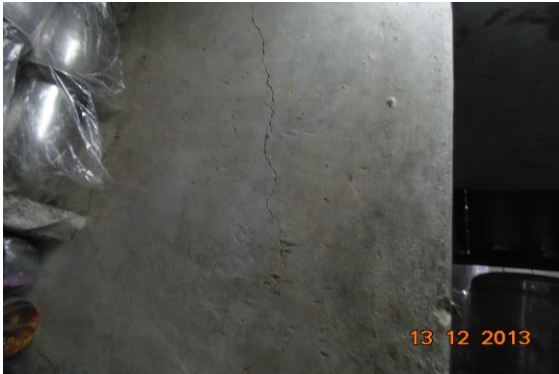
Photo 26

Inclined Crack on Part A, Shop No. 178, Basement
Approx. Width = 0.5mm, Approx. Length = 2m.
Height from Floor = 2m.

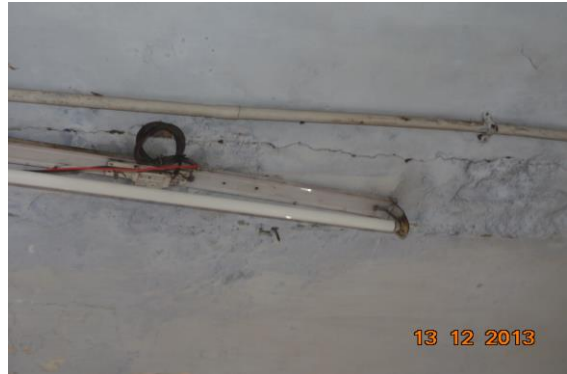
Photo 27

Horizontal Crack on Roof of Varanda, Shop No. 179, Ground Floor
Approx. Width = 0.6mm, Approx. Length = 3m.
Distance External Left Column = 0m, Height Floor = 3.2m.

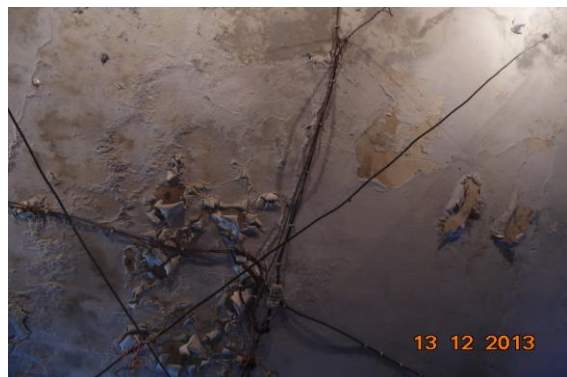
Photo 29

Horizontal Crack on Roof of Varanda, Shop No. 187, Ground Floor
Approx. Width = 0.5mm, Approx. Length = 3m. Distance from From Beam = 0m, Height from Floor = 3.6m.

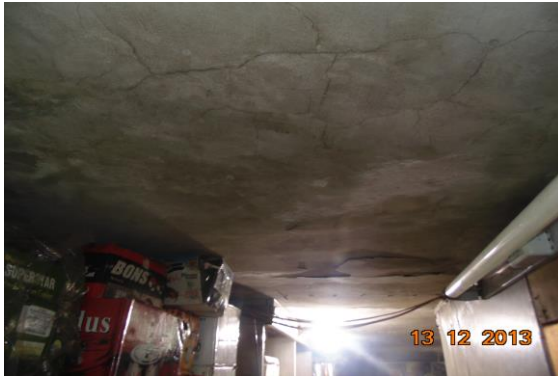
Photo 30
Peeling of Plaster on S.No.170A of Upper Ground Floor

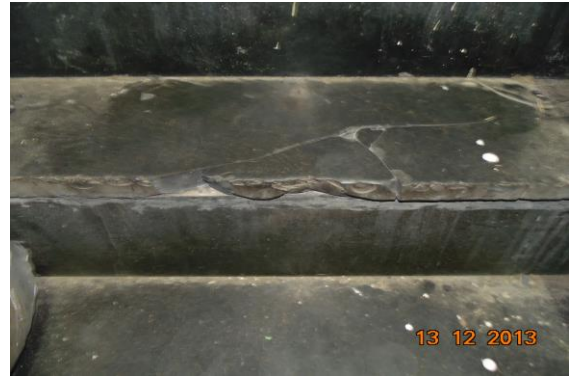
Photo 31
Dampness/Seepage on Stair Step GF to U/GF of Upper Ground Floor

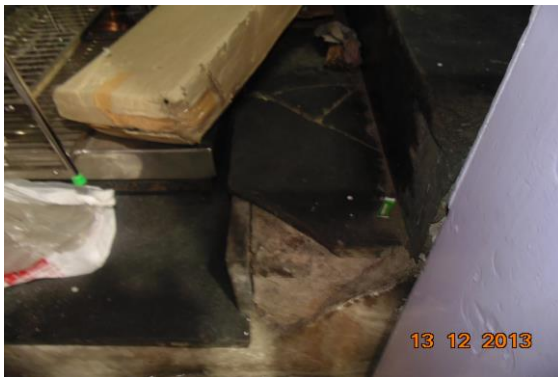
Photo 32
Dampness/Seepage on Stair Step GF to U/GF of Upper Ground Floor

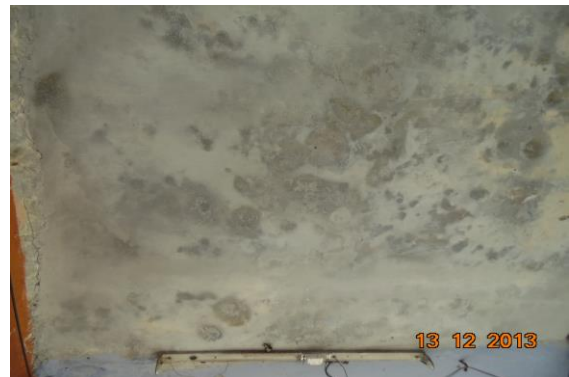
Photo 33
Dampness/Seepage on Roof of Varanda S.No.170A of Ground Floor

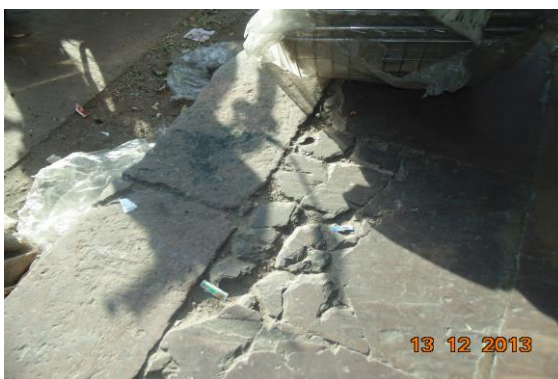
Photo 34
Damaged Portion on Floor of Varanda S.No.170A of Ground Floor

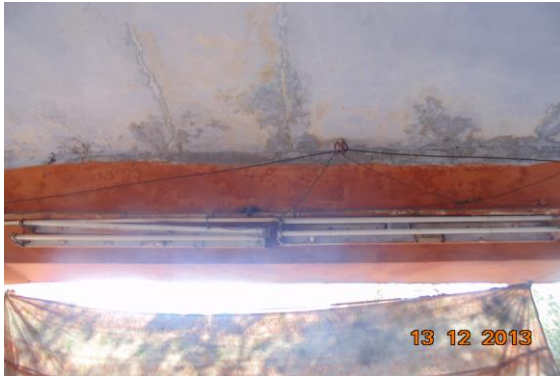
Photo 36
Dampness/Seepage on Roof & Beam of Varanda of Shop No. 171,
Ground Floor

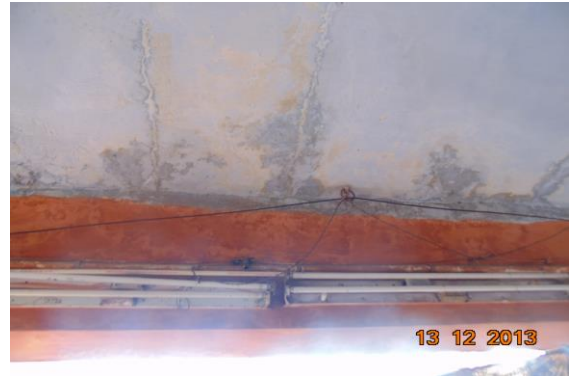
Photo 37
Plaster Crack on Roof & Beam of Varanda of Shop No. 171, Ground
Floor

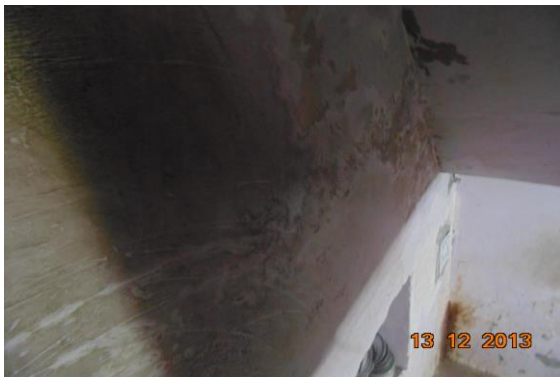
Photo 38
Peeling of Plaster on Stair case of Shop No. 171, Basement

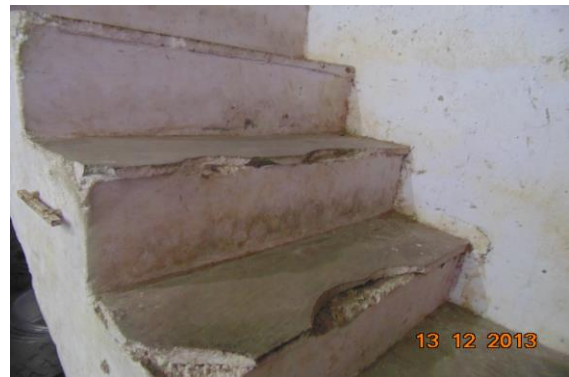
Photo 39
Dampness/Seepage on Stair Step of Shop No. 171, Basement

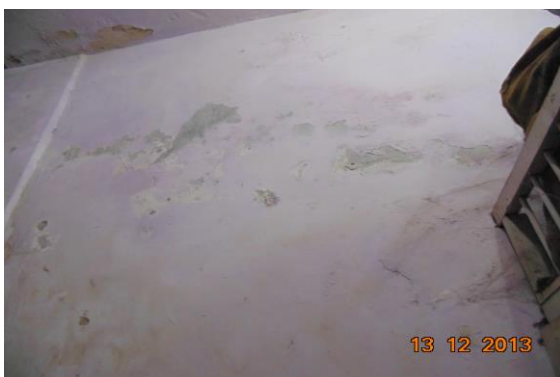
Photo 40
Dampness/Seepage on Basement of Shop No. 171, Basement

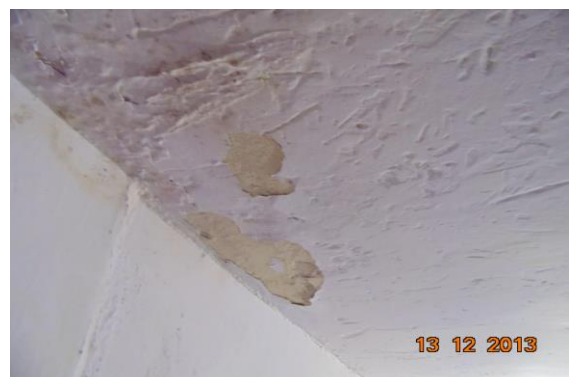
Photo 41
Peeling of Plaster on Roof of Shop No. 171 of Basement

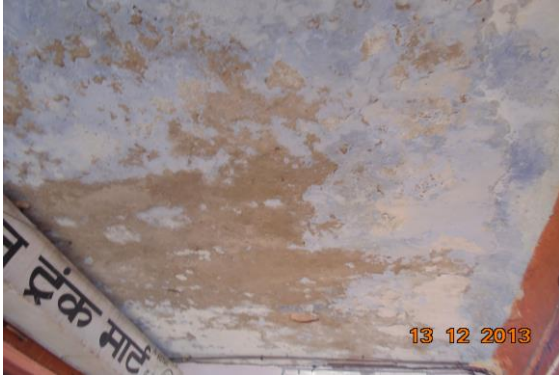
Photo 42

Dampness/Seepage on Roof of Varanda of Shop No.172, Ground Floor

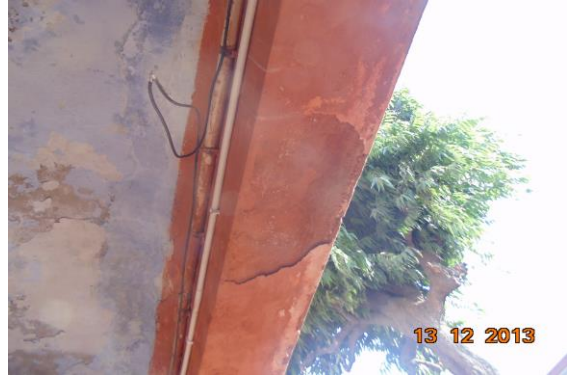
Photo 43

Dampness/Seepage on Roof & Beam of Varanda of Shop No.172, Ground Floor

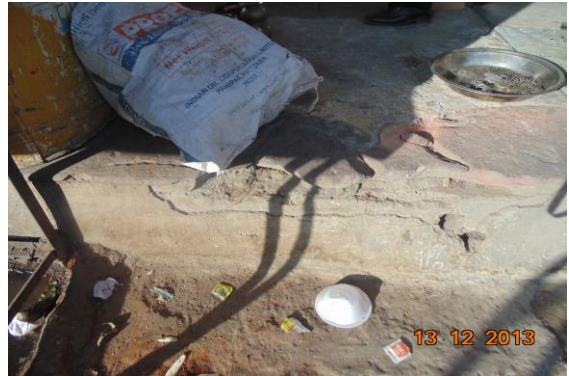
Photo 45

Dampness/Seepage on Floor of Varanda of Shop No.173, Ground Floor

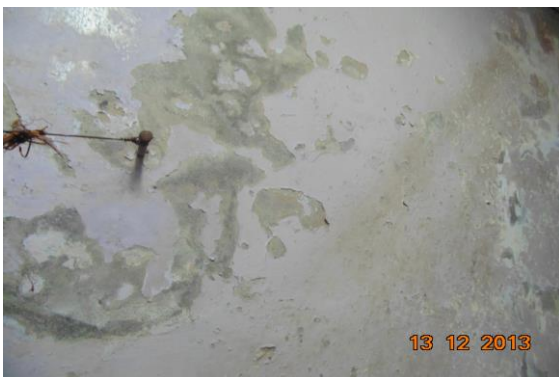
Photo 46

Dampness/Seepage on Floor of Shop No.173 of Basement

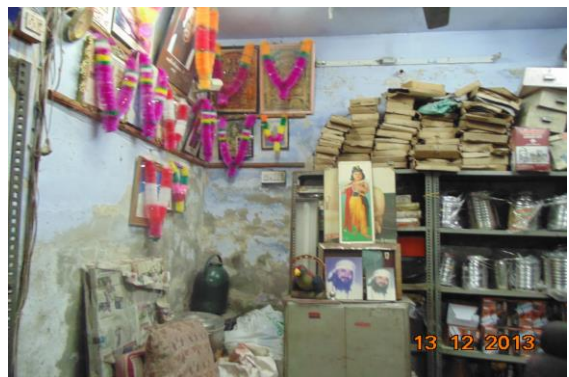
Photo 47

Dampness/Seepage on Floor of Shop No.173 of Basement

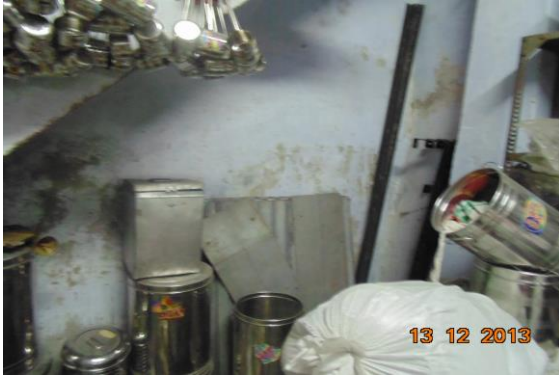
Photo 48
Dampness/Seepage on Floor of Shop No.173 of Basement

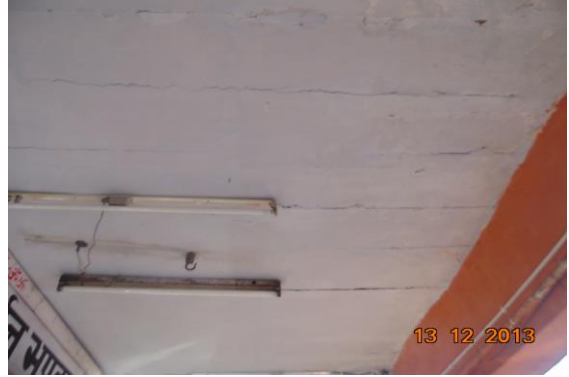
Photo 49
Peeling of Plaster on Roof of Varanda of Shop No.174, Ground Floor

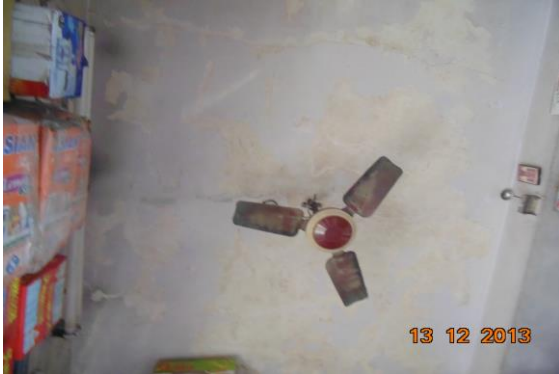
Photo 50
Dampness/Seepage on Roof of Shop No.174 of Ground Floor

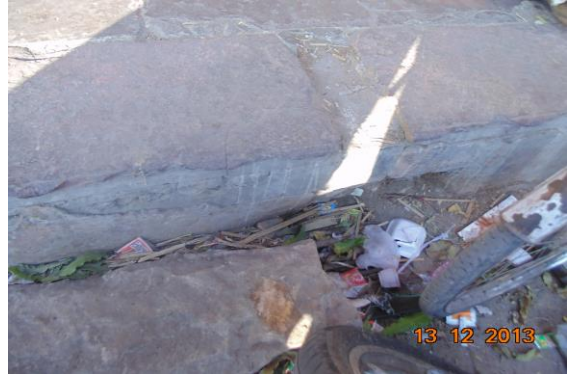
Photo 51
Dampness/Seepage on Floor of Varanda of Shop No.175, Ground Floor

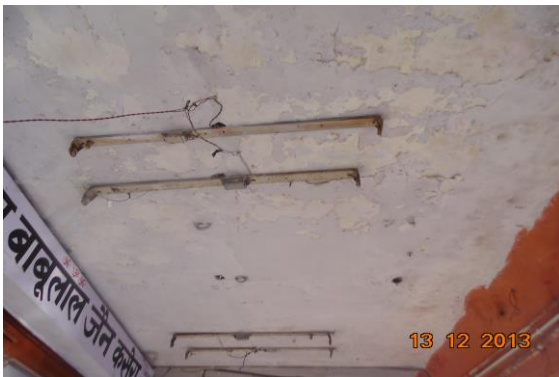
Photo 52
Dampness/Seepage on Roof of Varanda of Shop No.175, Ground Floor

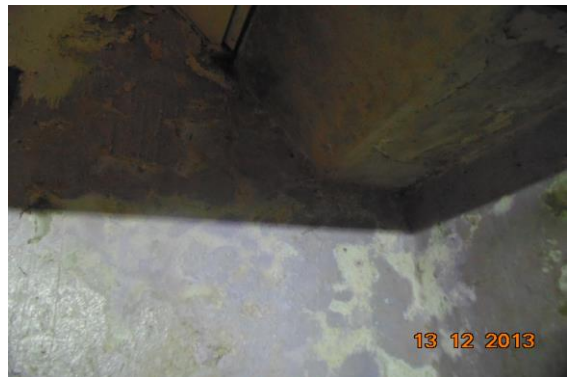
Photo 53
Dampness/Seepage on Roof, 1 & 4 of Stair Case of Shop No.175, Basement

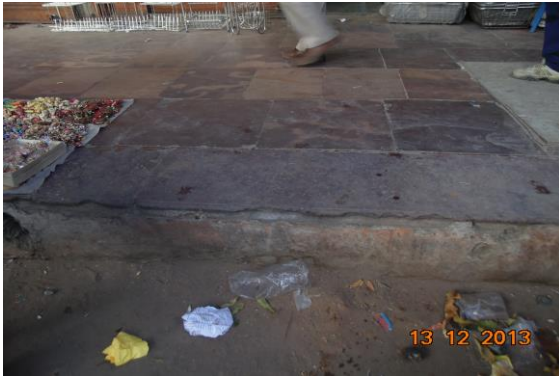
Photo 54

Dampness/Seepage on Floor of Varanda of Shop No.177, Ground Floor

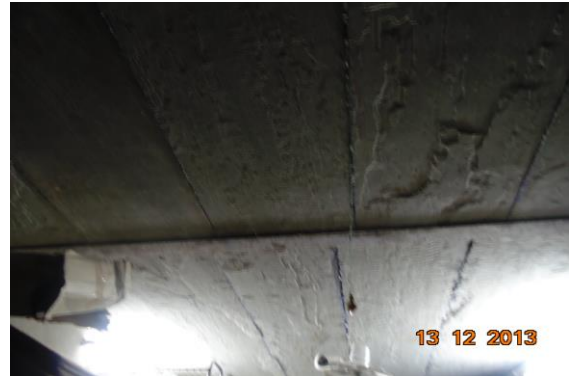
Photo 55

Peeling of Plaster on Roof of Shop No.177 of Basement

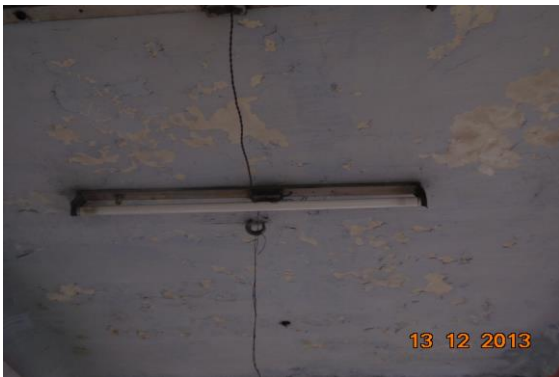
Photo 56

Dampness/Seepage on Roof of Varanda of Shop No. 178, Ground Floor

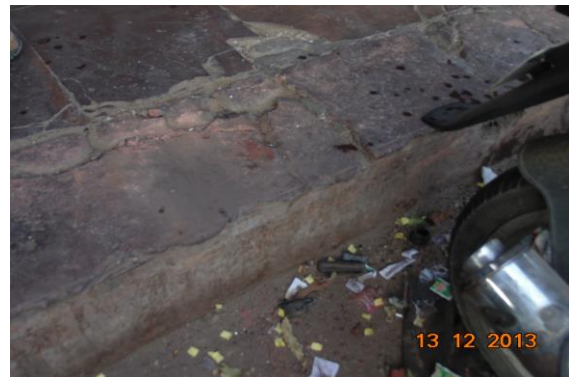
Photo 57

Dampness/Seepage on Floor of Varanda of Shop No. 178, Ground Floor

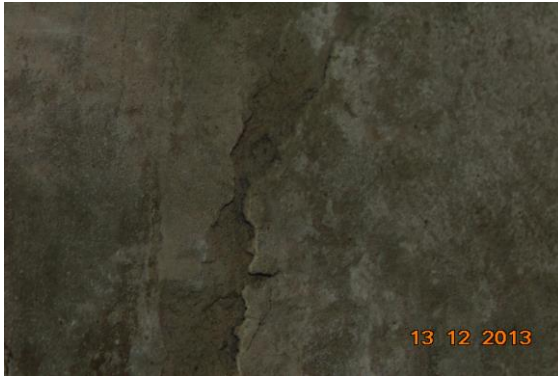
Photo 60
Plaster Crack on Part A of Shop No. 178, Basement

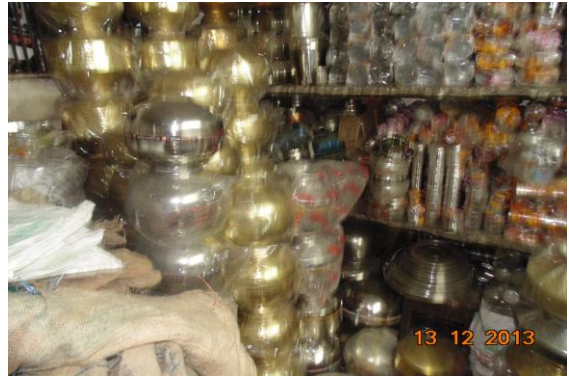
Photo 61
Plaster Crack on All Walls of Part A of Shop No. 178, Basement

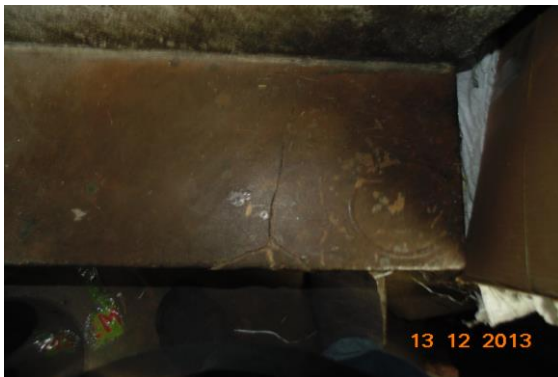
Photo 62
Damaged Portion on Stair Case GF to Basement of Shop No. 178, Basement

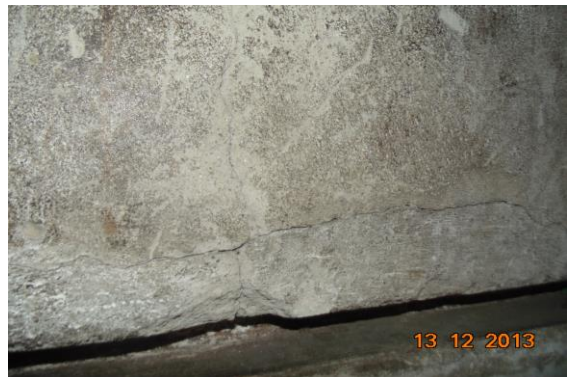
Photo 63
Plaster Crack on Stair Case GF to Basement of Shop No. 178, Basement

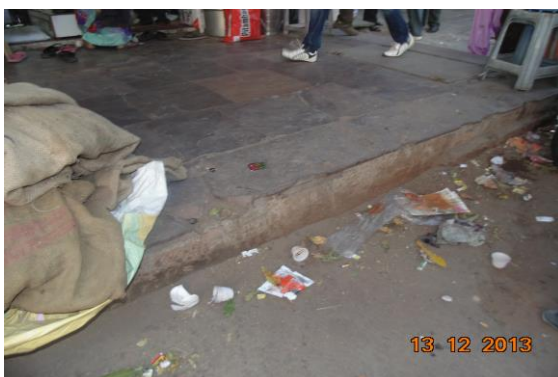
Photo 64
Dampness/Seepage on Floor of Varanda of Shop No. 179, Ground Floor

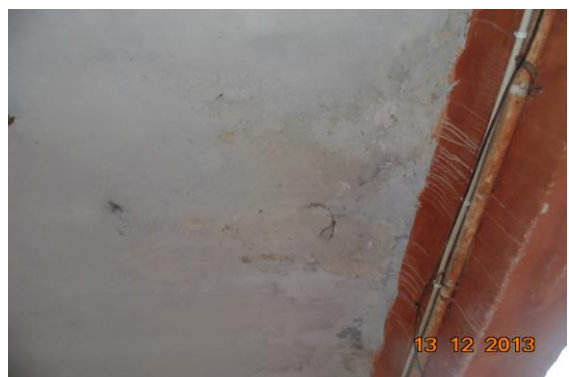
Photo 65
Dampness/Seepage on Roof of Varanda of Shop No. 179, Ground Floor

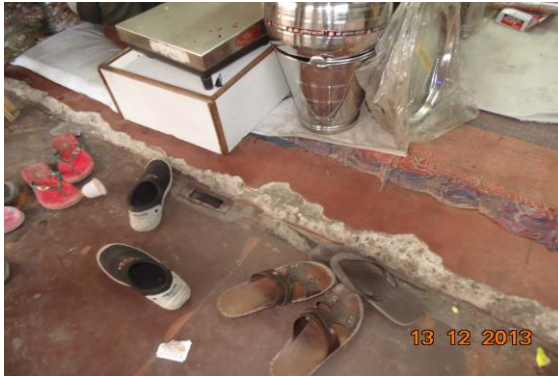
Photo 66

Dampness/Seepage on Floor & 2 of Varanda of Shop No. 179, Ground Floor

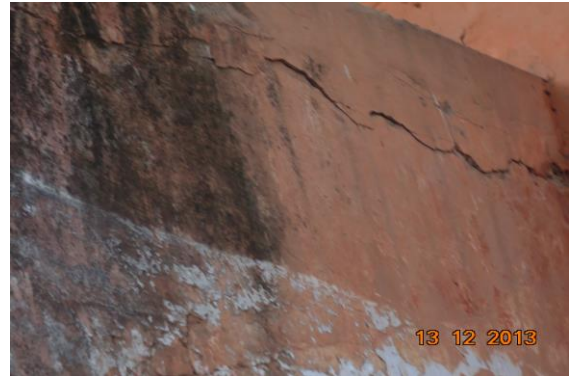
Photo 67

Dampness/Seepage on Floor & 2 of Varanda of Shop No. 179, Ground Floor

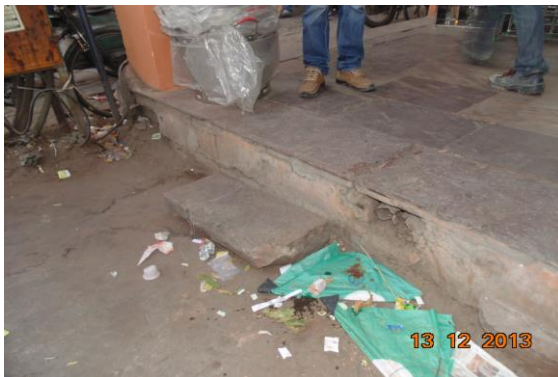
Photo 68

Dampness/Seepage on Floor of Varanda Gate of Shop No. 180, Ground Floor

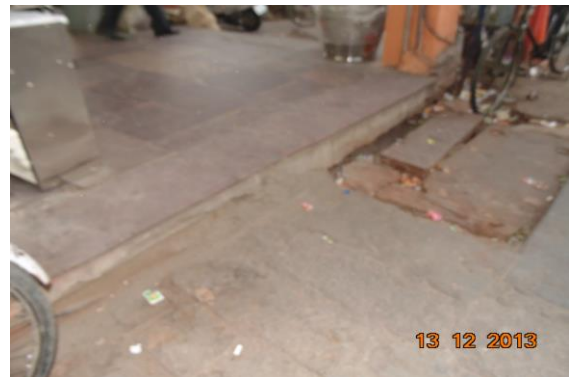
Photo 69

Dampness/Seepage on Floor of Varanda Gate of Shop No. 180, Ground Floor

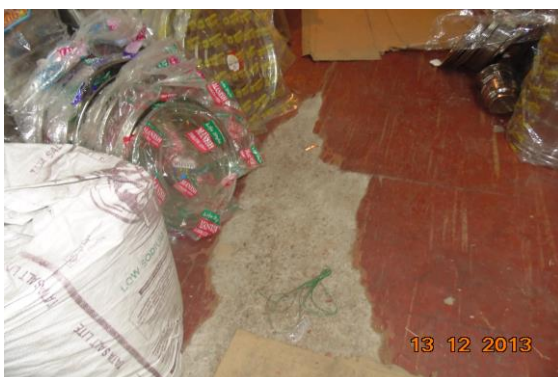
Photo 70

Peeling of Plaster on Floor of Shop No. 180 of Upper Ground Floor

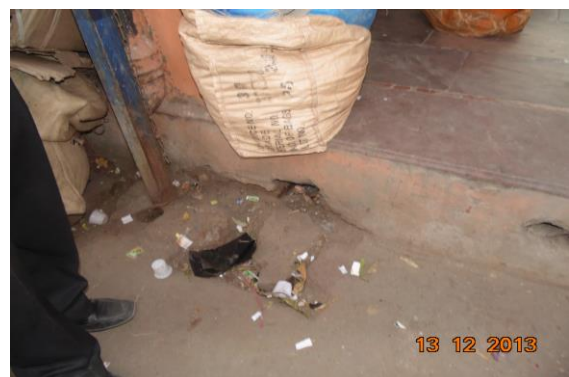
Photo 71

Dampness/Seepage on Floor of Varanda of Shop No. 181, Ground Floor

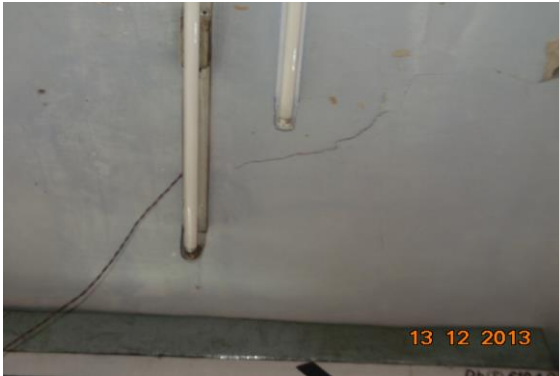
Photo 72

Peeling of Plaster on Roof of Varanda of Shop No.181, Ground Floor

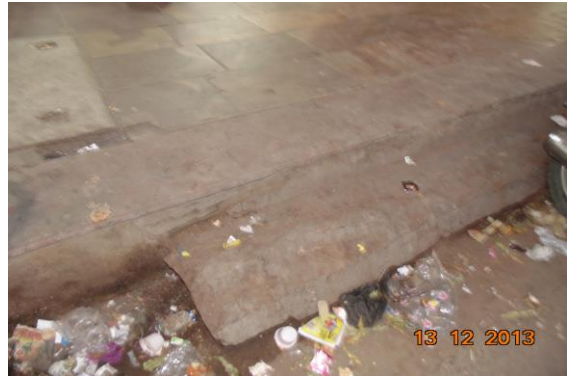
Photo 73

Dampness/Seepage on Floor of Varanda of Shop No. 182, Ground Floor

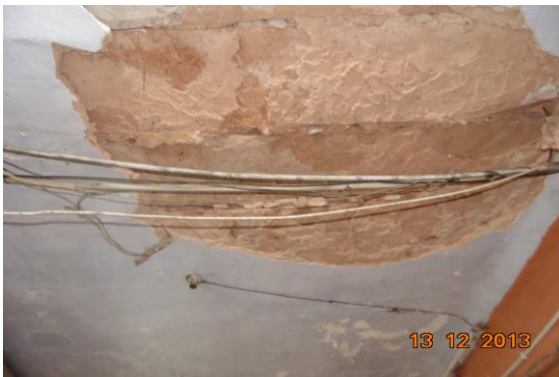
Photo 74

Peeling of Plaster on Roof of Varanda of Shop No. 182, Ground Floor

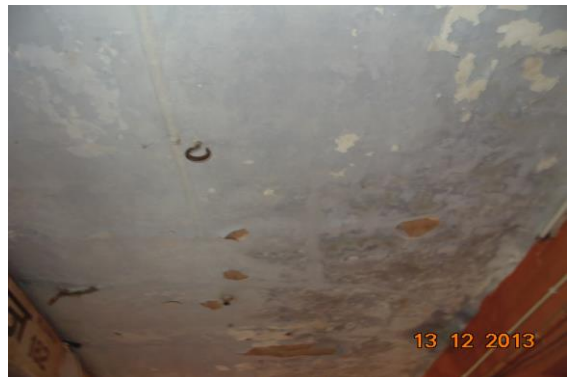
Photo 75

Dampness/Seepage on Roof of Varanda of Shop No. 182, Ground Floor

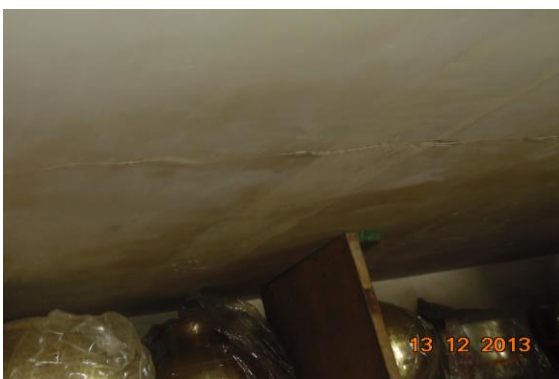
Photo 76

Plaster Crack on Floor of Part 2 of Shop No. 182, Upper Ground Floor

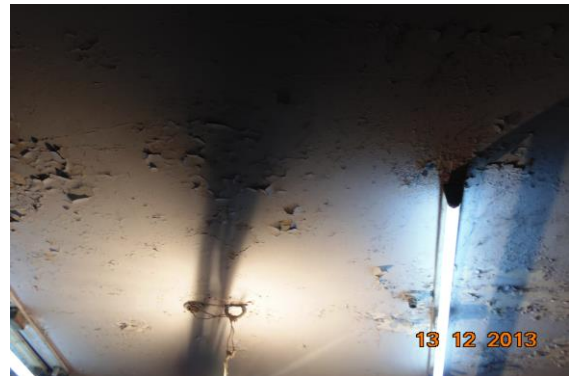
Photo 79

Dampness/Seepage on Roof of Varanda of Shop No. 185, Ground Floor

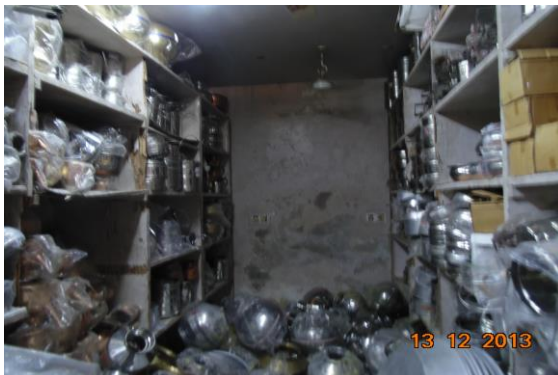
Photo 80

Peeling of Plaster on Roof of Shop No. 185 of Basement

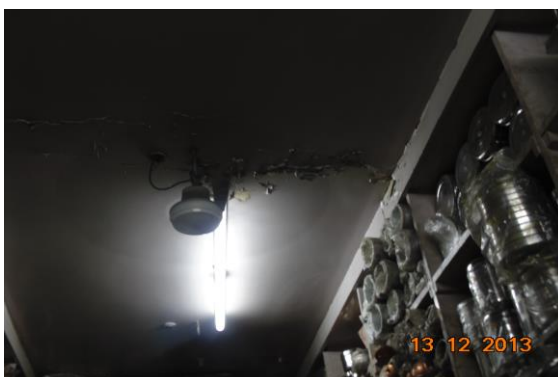
Photo 81

Dampness/Seepage on Roof of Shop No. 185 of Basement

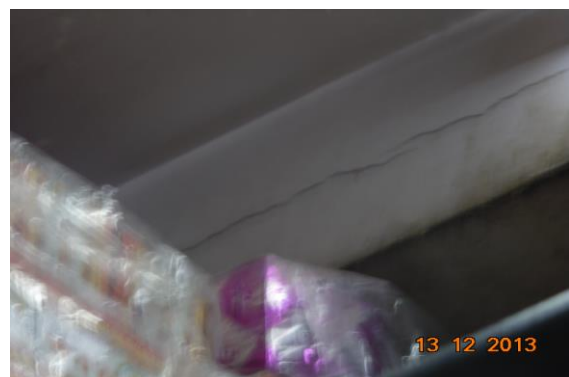
Photo 82

Peeling of Plaster on Roof of Shop No. 185 of Upper Ground Floor

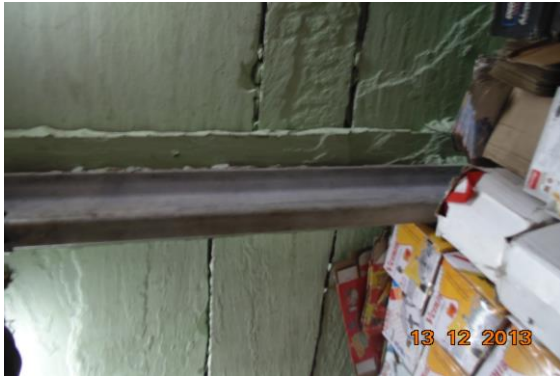
Photo 83

Plaster Crack on Roof of Shop No. 185 of Upper Ground Floor

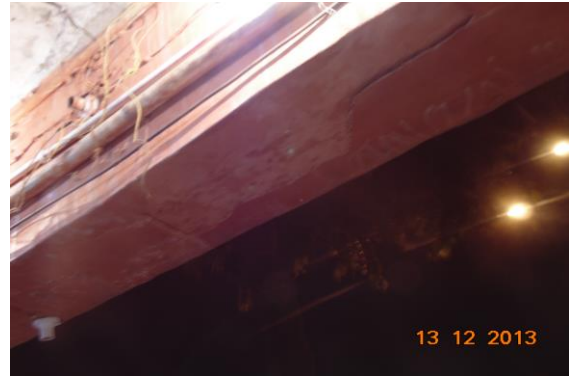
Photo 84
Peeling of Plaster on Roof of Shop No. 186 of Basement

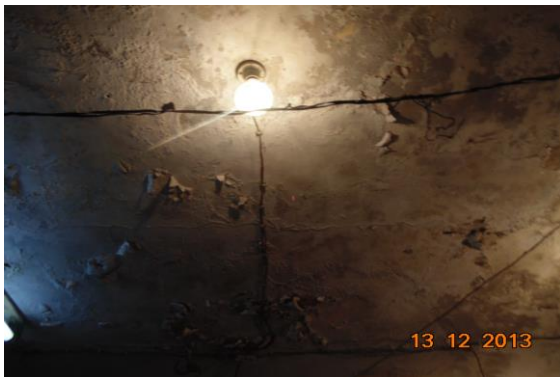
Photo 85
Peeling of Plaster on Roof & Beam of Varanda of Shop No. 187, Ground Floor

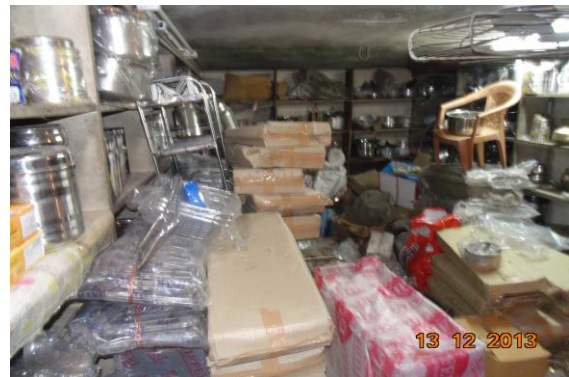
Photo 86
Dampness/Seepage on Roof of Varanda of Shop No. 187, Ground Floor

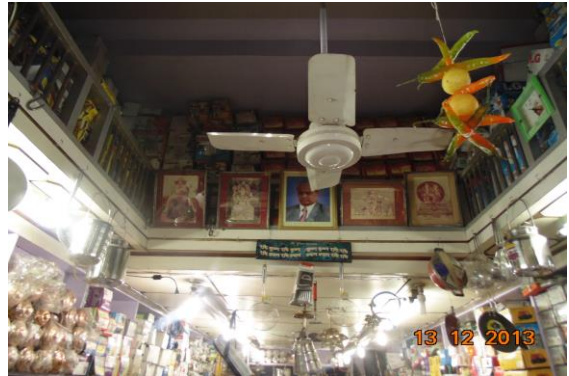
Photo 120

Roof of Shop No. 179 of Ground Floor Covered with Wood & Materials

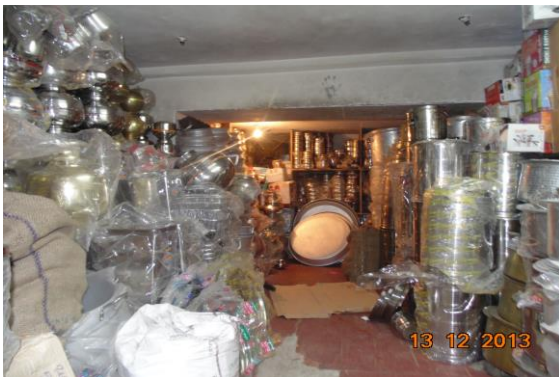
Photo 121

All Walls of Shop No. 179 of Ground Floor Covered with Wood & Materials

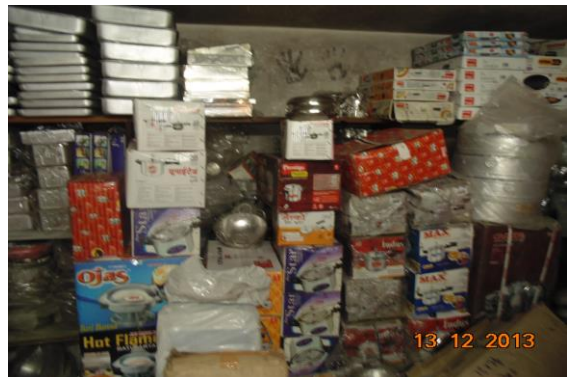
Photo 122

All Walls of Shop No. 180 of Upper Ground Floor Covered With Wood & Material

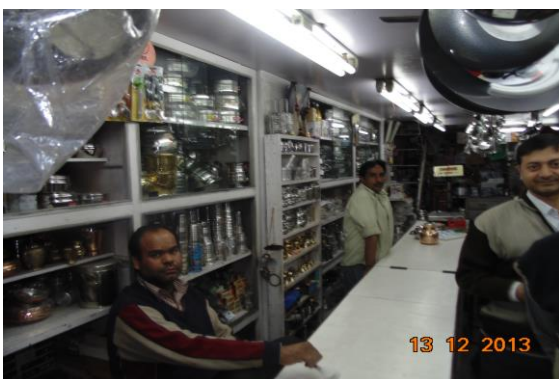
Photo 123

Floor & 3 of Shop No. 180 of Upper Ground Floor Covered With Wood & Material

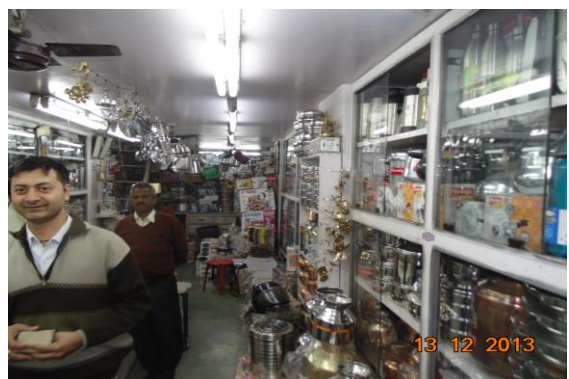
Photo 124

Floor & 3 of Shop No. 180 of Ground Floor Covered With Wood & Material

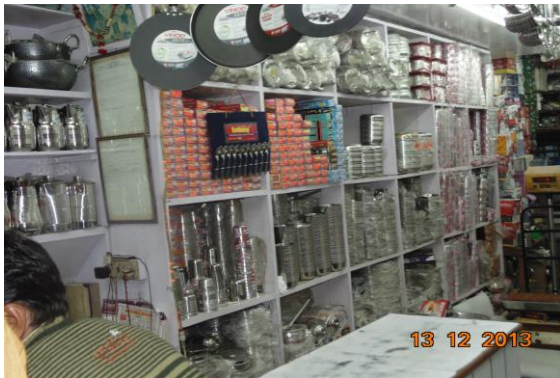
Photo 125

Floor & 3 of Shop No. 180 of Ground Floor Covered With Wood & Material

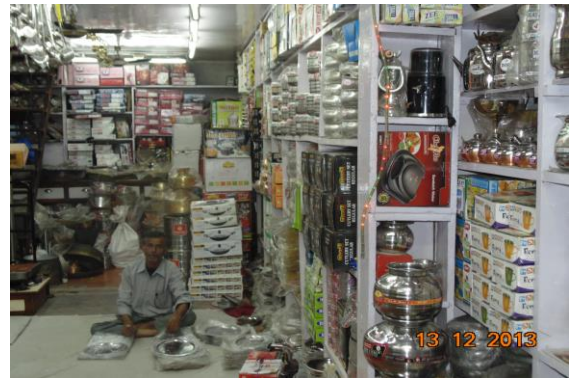
Photo 126

Roof of Shop No.181 of Ground Floor Covered With Wood & Material

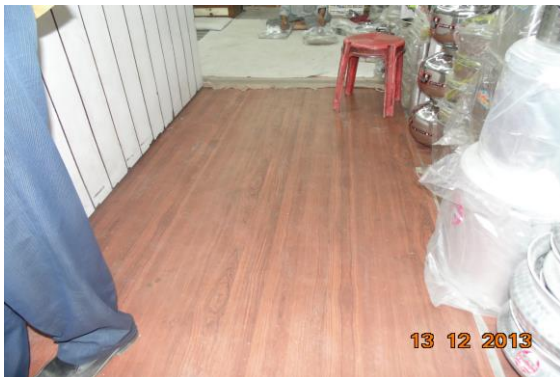
Photo 127

Roof of Shop No.181 of Ground Floor Covered With Wood & Material

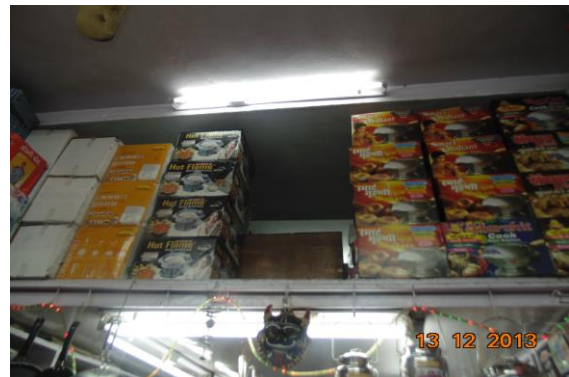
Photo 128

Floor of Shop No.181 of Ground Floor Covered With Material

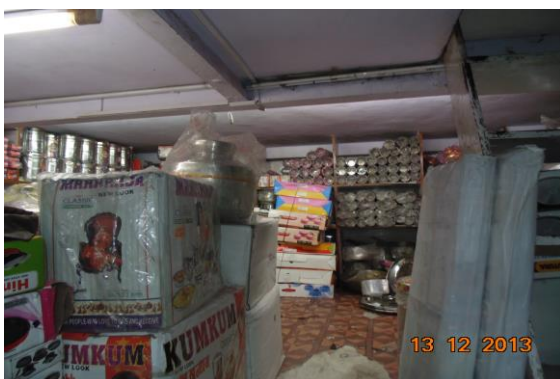
Photo 129

All Walls of Shop No.181 of Upper Ground Floor Covered With Wood & Material

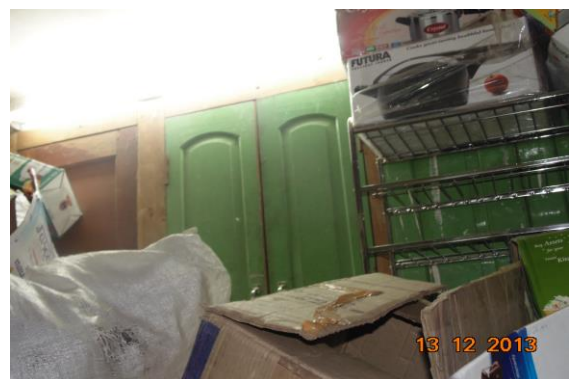
Photo 130

Part 2 of Shop No. 182, Upper Ground Floor Covered with Wood & Material

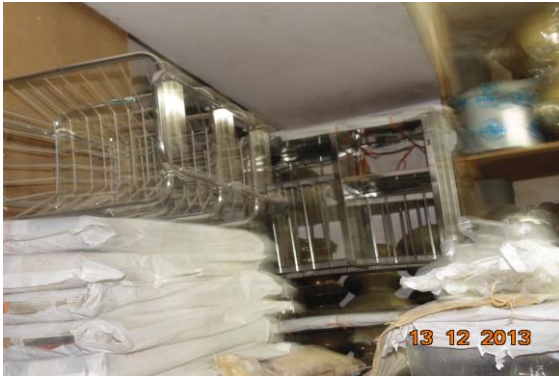
Photo 131

Floor of Shop No. 182 of Ground Floor Covered with Wood & Material

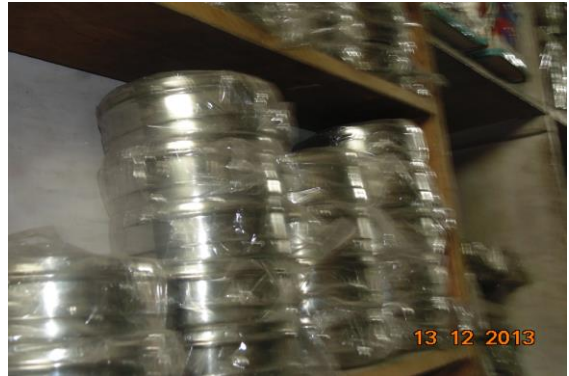
Photo 132

Floor of Shop No. 182 of Ground Floor Covered with Wood & Material

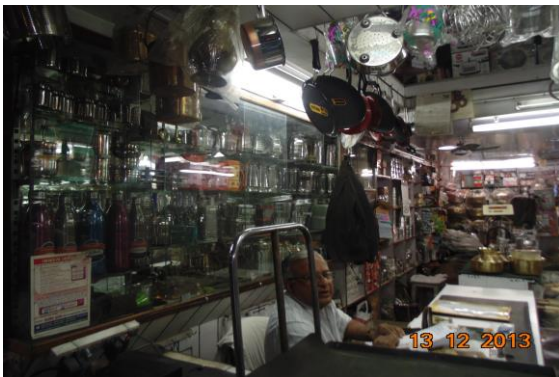
Photo 133

Floor of Shop No. 182 of Ground Floor Covered with Wood & Material

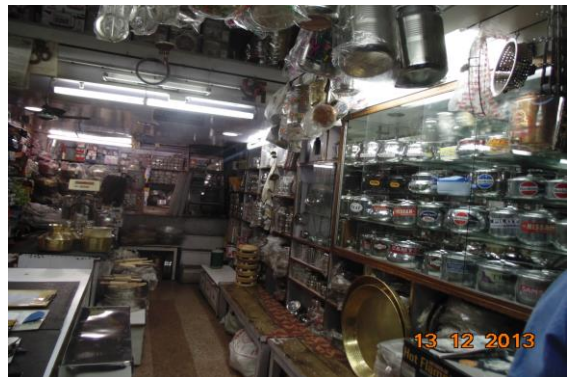
Photo 134

Roof of Part 2 of Shop No. 182, Upper Ground Floor Covered with Wood & Material

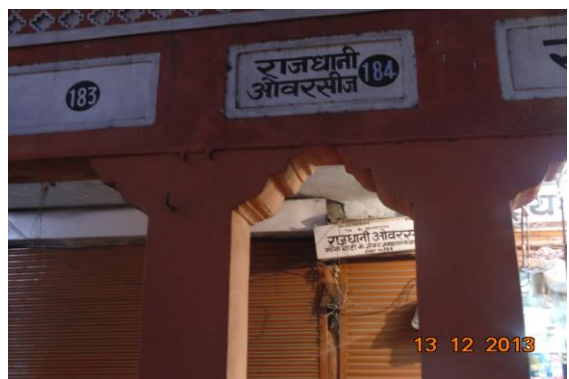
Photo 136

All Walls of Shop No. 183 of Ground Floor LOCKED

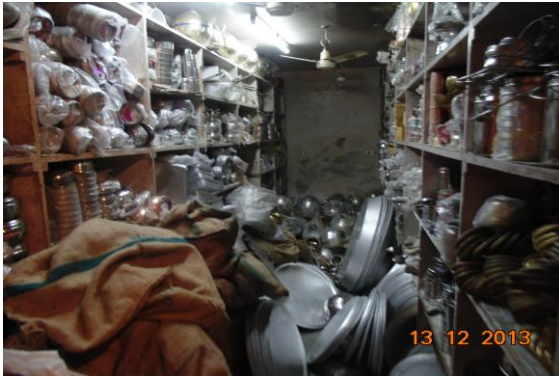
Photo 137

All Walls of Shop No. 184 of Ground Floor LOCKED

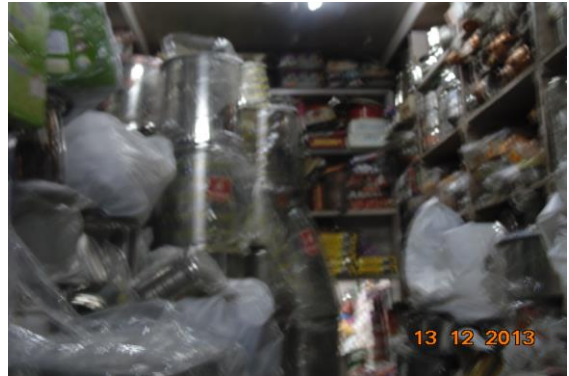
Photo 138

Roof of Shop No. 185 of Basement Covered with Wood & Material

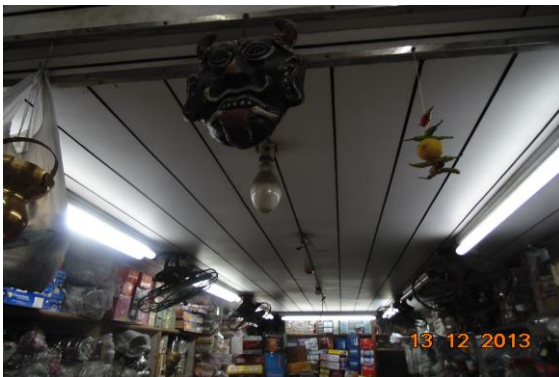
Photo 139

All walls of Shop No. 185 of Upper Ground Floor Covered with Wood & Material

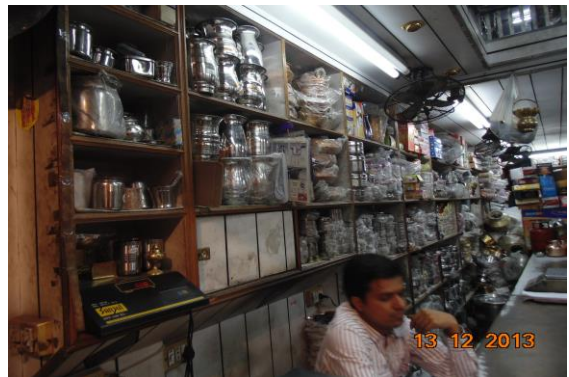
Photo 140

Roof & 1 of Shop No. 185 of Ground Floor Covered with False Ceiling

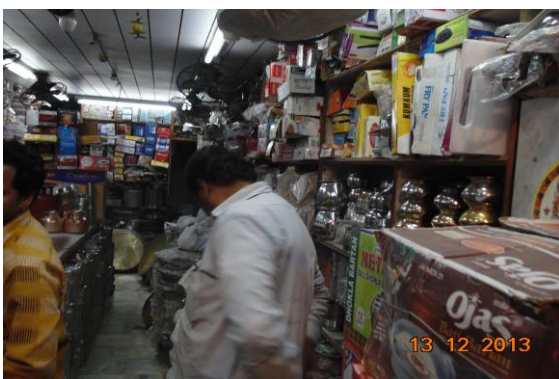
Photo 141

Roof & 1 of Shop No. 185 of Ground Floor Covered with Wood & Material

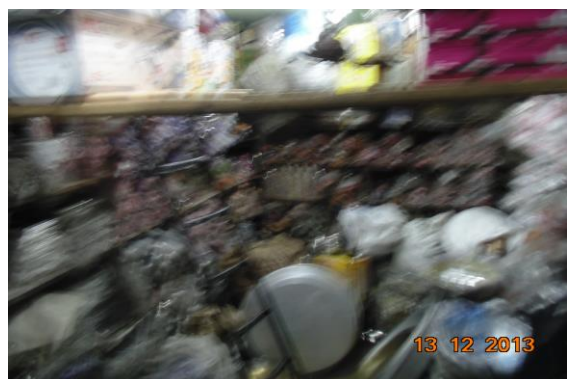
Photo 142

Roof & 1 of Shop No. 185 of Ground Floor Covered with Wood & Material

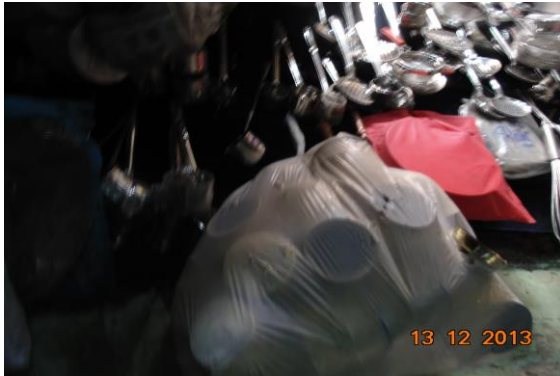
Photo 143

Roof of Shop No. 186 of Basement Covered with Wood & Material

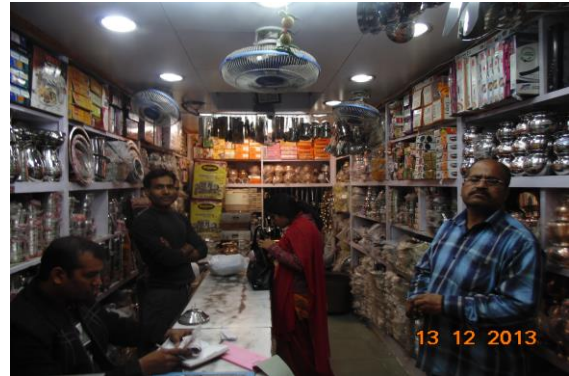
Photo 144

Roof of Shop No. 186 of Basement Covered with Wood & Material

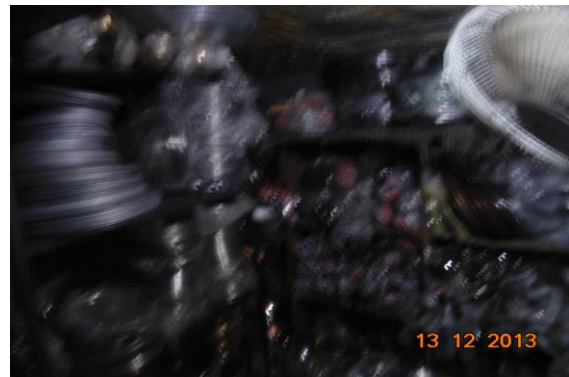
Photo 146

All wall of Shop No. 186, Upper Ground Floor Covered with Wood

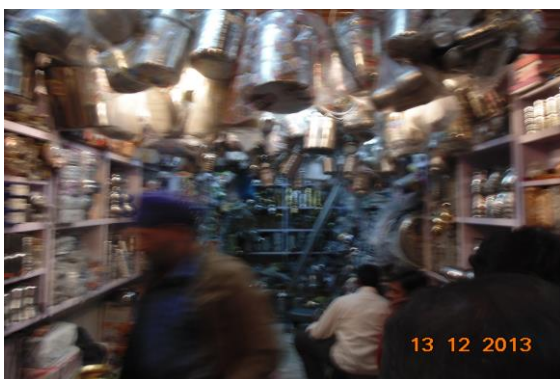
Photo 147

All wall of Shop No. 187 of Basement Covered with Wood & Material

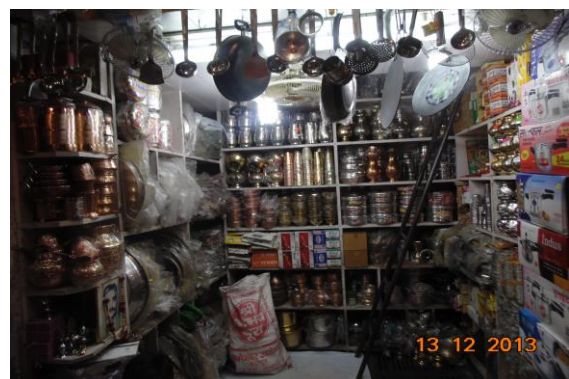
Photo 148

All wall of Shop No. 187 of Ground Floor Covered with Wood & Material

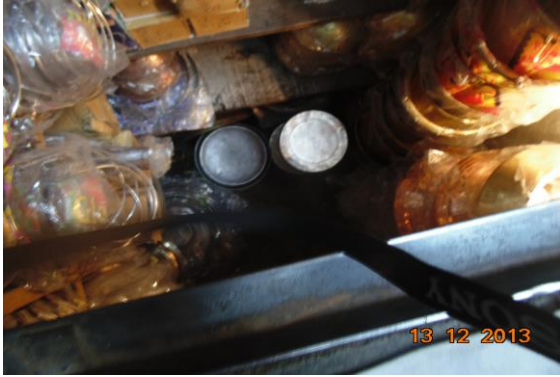
Photo 149

Shop No. 188 of Ground Floor Covered with Wood & Material

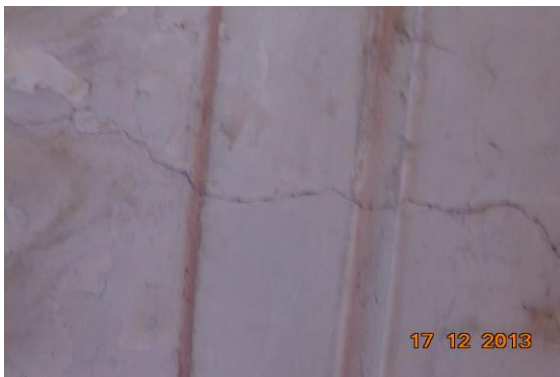
Photo 14

Inclined Crack on Wall No. 1 of Varanda, Ground Floor
Approx. Width = 1.5mm, Approx. Length = 1.7m.
Distance from Wall No.3 = 0m, Height from Floor = 2.5m.

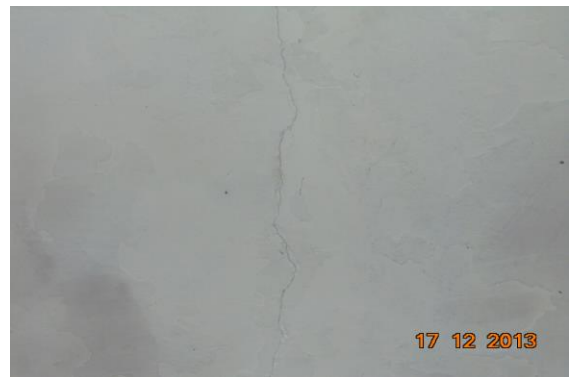
Photo 15

Horizontal Crack on Roof of Varanda No.2, Ground Floor
Approx. Width = 0.5mm, Approx. Length = 1.2m.
Distance from Wall No.1 = 3.5m, Height from Floor = 3m.

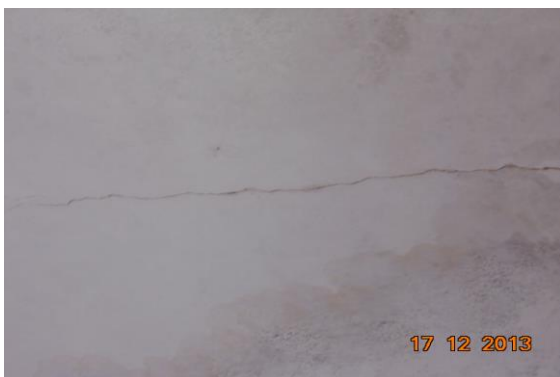
Photo 16

Horizontal Crack on Roof of Room No. 1, Temple Shri Sankat Haran Mahadev, Ground Floor Approx. Width = 0.5mm, Approx. Length = 1m.
Distance from Wall No.1 = 2.7m, Height Floor = 3m.

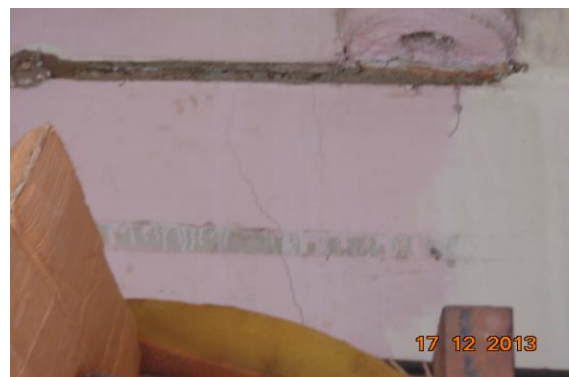
Photo 17

Horizontal Crack on Roof of Shop No.128, Ground Floor
Approx. Width = 0.8mm, Approx. Length = 2.5m.
Distance from Wall No.1 = 3m, Height from Floor = 4m.

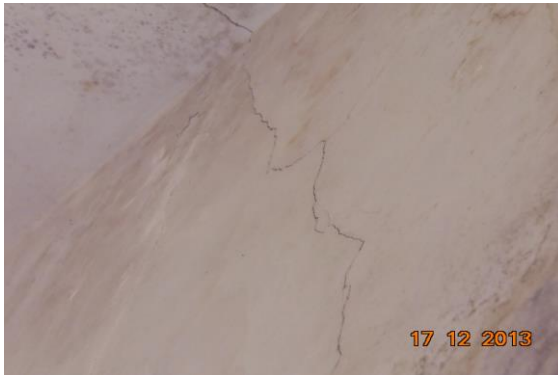
Photo 18

Inclined Crack on Wall No. 4 of Shop No.128, Ground Floor
Approx. Width = 0.6mm, Approx. Length = 1.2m.
Distance from Wall No.1 = 2m, Height from Floor = 2.6m.
