Pre Building Condition Survey Report

Name and Address of Structure :	Choti Chopar to Badi Chopar (UP Line)
---------------------------------	---------------------------------------

Name of the Project	Contract JMRC-UG1B “Design and Construction of Tunnel between Chandpole and Badi Chouper and reverse line by Shield TBM, Underground Metro Stations at Choti Chouper and Badi Chouper by Cut and Cover Methods on East West Corridor of Jaipur Metro Rail Corporation Limited .”	
Owner :

Shoping Complex - Shop No. 169-188
Tripolia Bazar
Jaipur
Unique ID: CC BC UP 0001

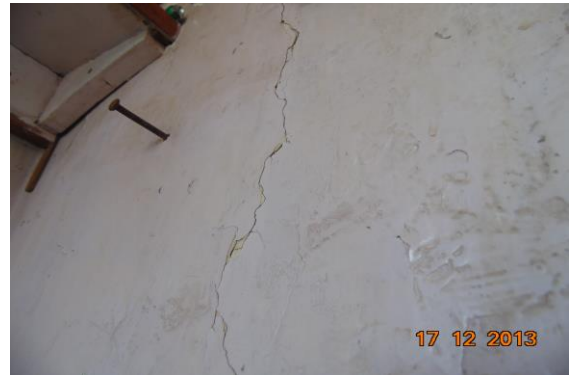
Photo 19

Inclined Crack on Wall No. 3 of Shop No.128, Ground Floor
Approx. Width = 0.8mm, Approx. Length = 1.5m.
Distance from Wall No.1 = 2.5m, Height from Floor = 3m.

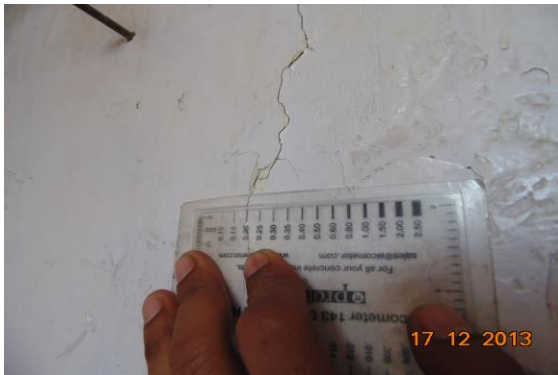
Photo 20

Vertical Crack on Wall No. 1 of Shop No.125, Ground Floor
Approx. Width = 0.2mm, Approx. Length = 2.2m.
Distance from Wall No.3 = 2m, Height from Floor = 0m.

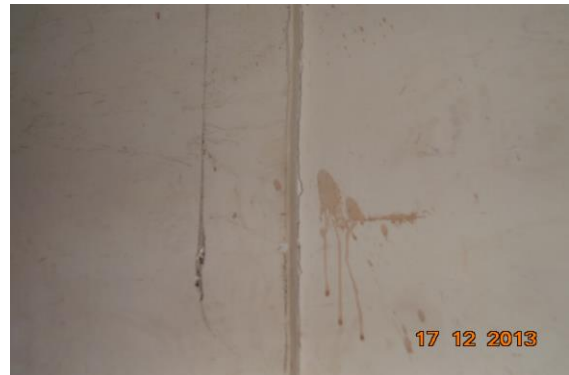
Photo 20A

Vertical Crack on Wall No. 1 of Shop No.125, Ground Floor
Approx. Width = 0.2mm, Approx. Length = 2.2m.
Distance from Wall No.3 = 2m, Height from Floor = 0m.

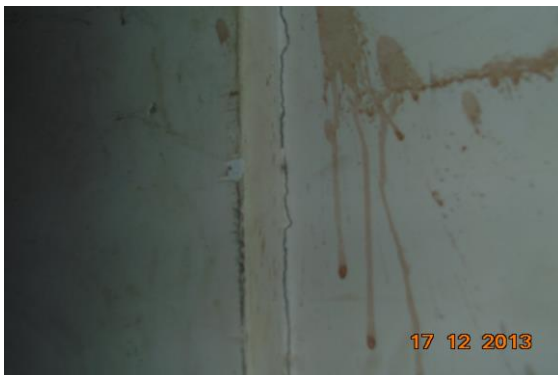
Photo 21

Vertical Crack on Wall No. 2 of Shop No.129, Ground Floor
Approx. Width = 1.5mm, Approx. Length = 2m.
Distance from Wall No.4 = 4m, Height from Floor = 0m.

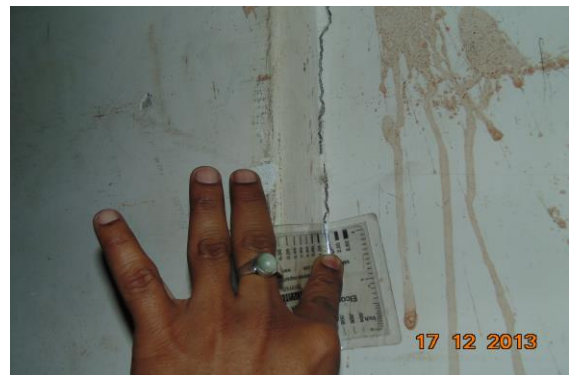
Photo 21A

Vertical Crack on Wall No. 2 of Shop No.129, Ground Floor
Approx. Width = 1.5mm, Approx. Length = 2m.
Distance from Wall No.4 = 4m, Height from Floor = 0m.

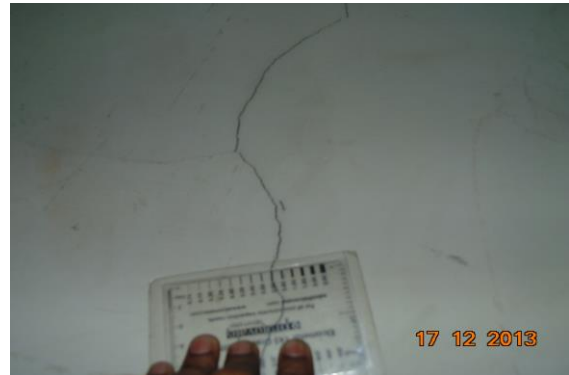
Photo 22

Inclined Crack on Wall No. 4 of Shop No.129, Ground Floor
Approx. Width = 0.6mm, Approx. Length = 2.1m.
Distance from Wall No.1 = 0.9m, Height from Floor = 0.7m.

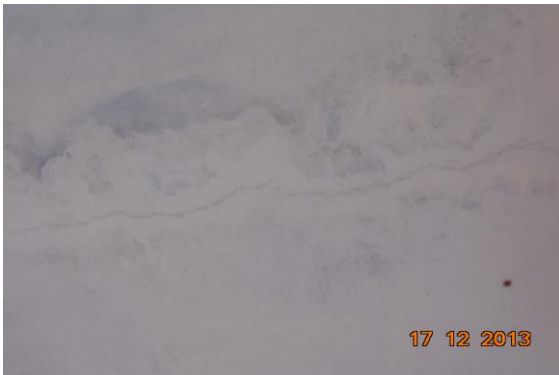
Photo 22A

Inclined Crack on Wall No. 4 of Shop No.129, Ground Floor
Approx. Width = 0.6mm, Approx. Length = 2.1m.
Distance from Wall No.1 = 0.9m, Height from Floor = 0.7m.

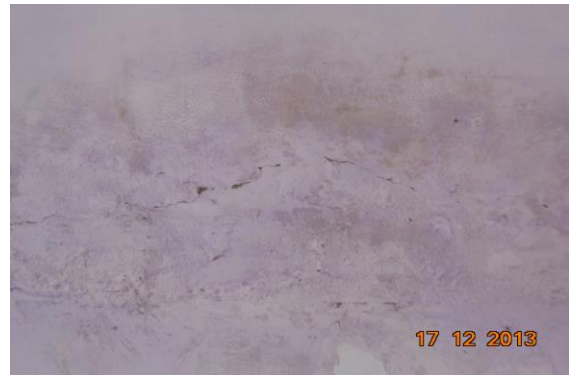
Photo 23

Horizontal Crack on Roof of Varanda of Shop No.57, Ground Floor
Approx. Width = 0.3mm, Approx. Length = 2m.

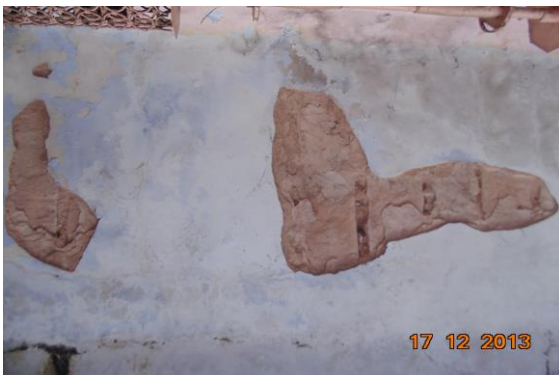
Photo 24

Horizontal Crack on Roof of Varanda of Shop No.84, Ground Floor
Approx. Width = 0.7mm, Approx. Length = 2m. Distance from Rightside
External Column = 0m, Height from Floor = 3.5m.

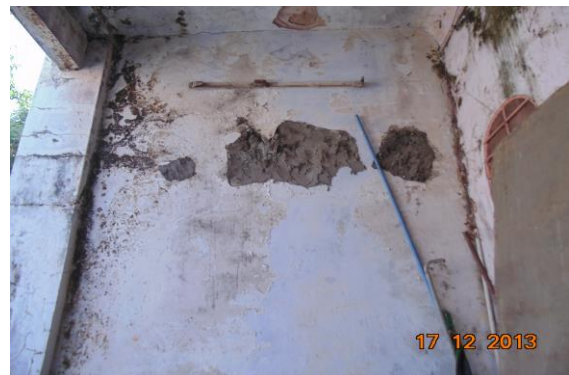
Photo 25

Peeling of Plaster on Roof of Varanda of Ground Floor

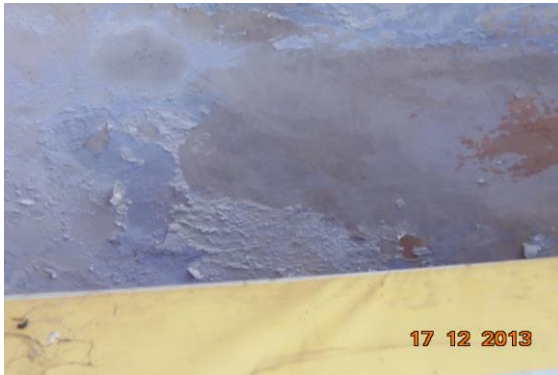
Photo 26

Peeling of Plaster on Wall No. 1 of Varanda of Ground Floor

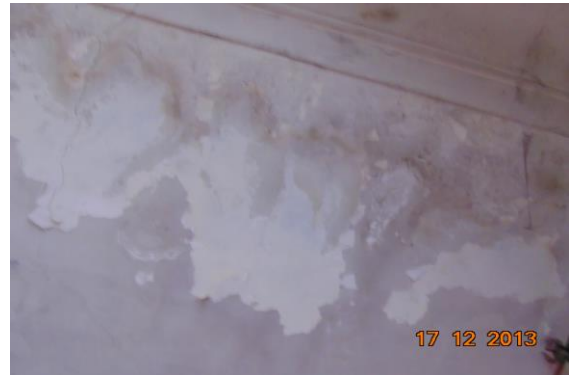
Photo 27
Dampness/Seepage on Roof of Varanda of Ground Floor

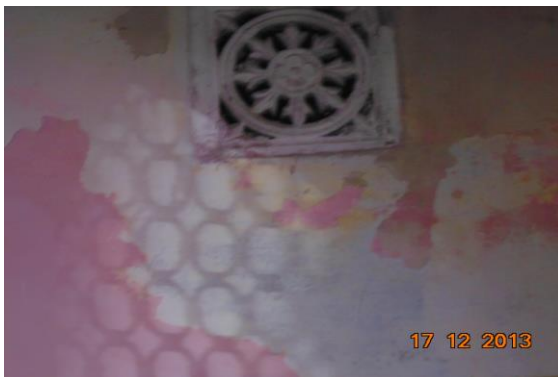
Photo 28
Dampness/Seepage on Roof of Varanda No.2 of Ground Floor

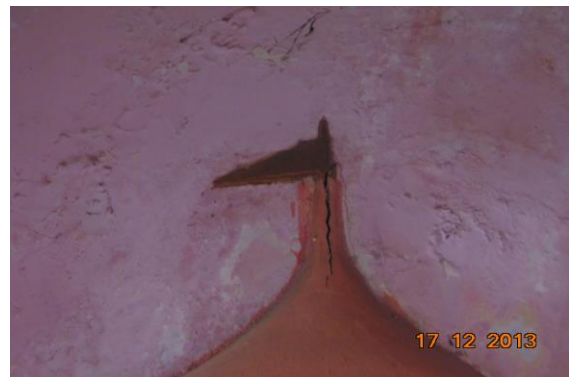
Photo 29
Peeling of Plaster on Wall No. 2 of Varanda No.2 of Ground Floor

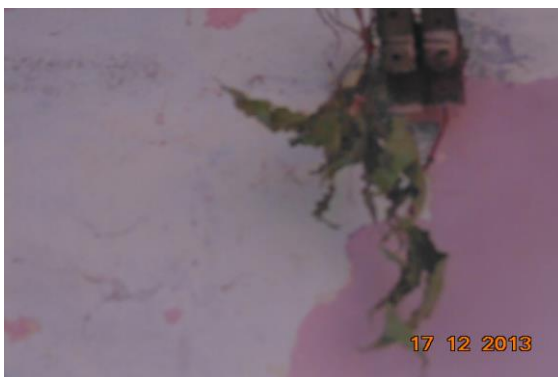
Photo 30
Dampness/Seepage on Wall No. 1 of Varanda No.2 of Ground Floor

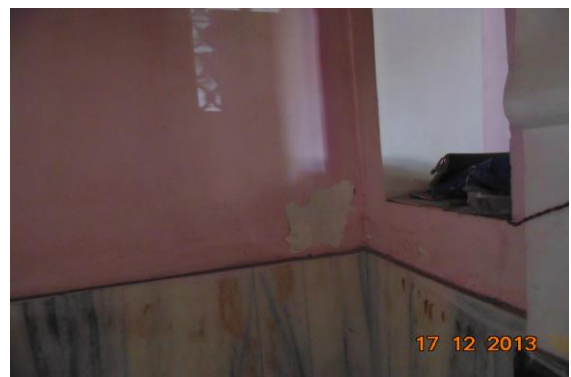
Photo 31
Peeling of Plaster on Wall No. 3 of Varanda No.2 of Ground Floor

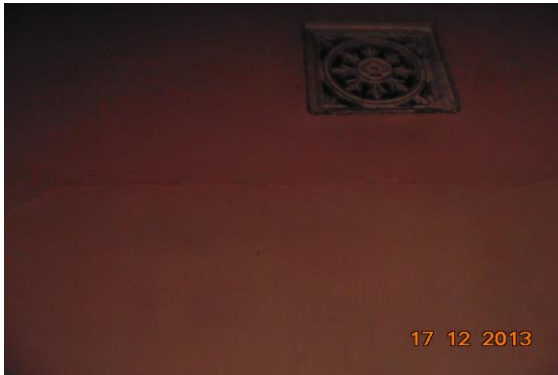
Photo 32
Peeling of Plaster on Wall No. 2 of Room No. 1 of Temple Shri Sankat Haran Mahadev, Ground Floor

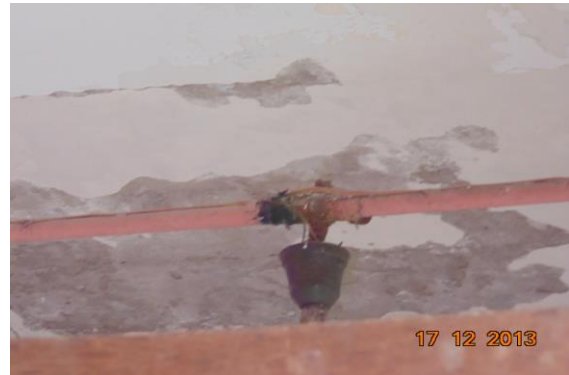
Photo 33

Peeling of Plaster on Wall No. 2 of Room No. 1 of Temple Shri Sankat Haran Mahadev, Ground Floor

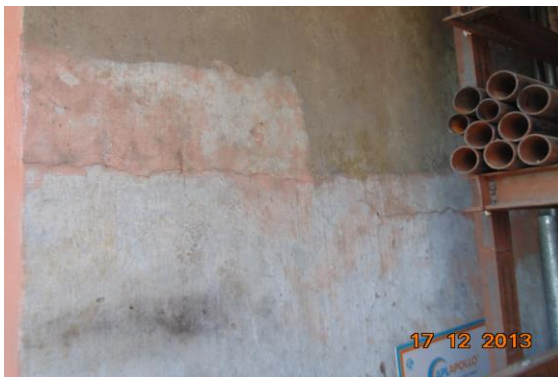
Photo 34

Peeling of Plaster on Roof of Shop No.128 of Ground Floor

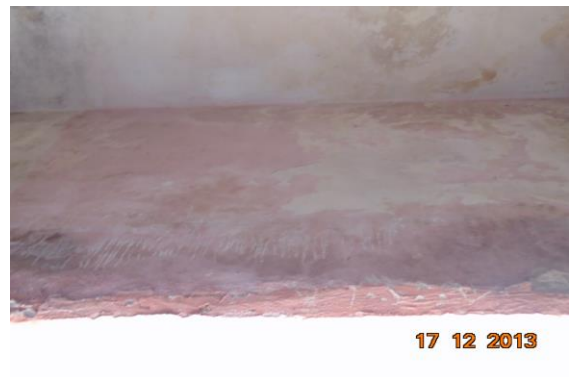
Photo 35

Peeling of Plaster on Wall No. 1 of Shop No.128 of Ground Floor

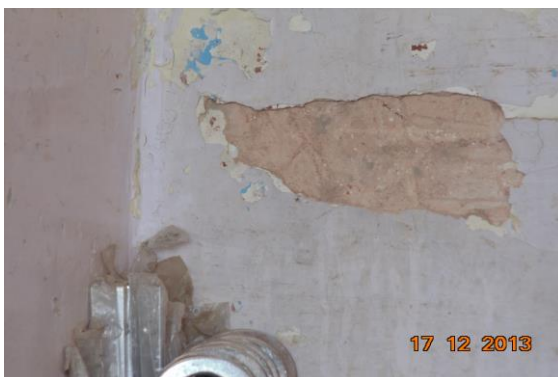
Photo 36

Dampness/Seepage on Wall No. 3 of Shop No.128 of Ground Floor

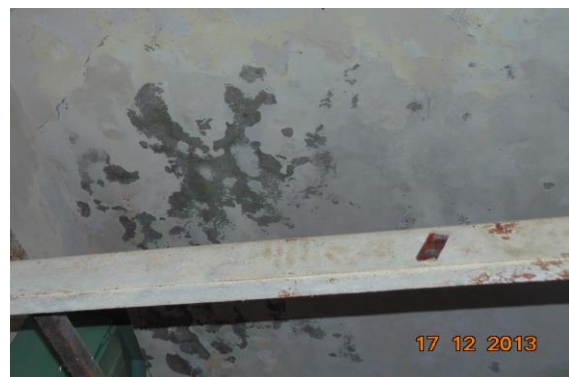
Photo 37

Peeling of Plaster on Wall No. 1 of Shop No.125 of Ground Floor

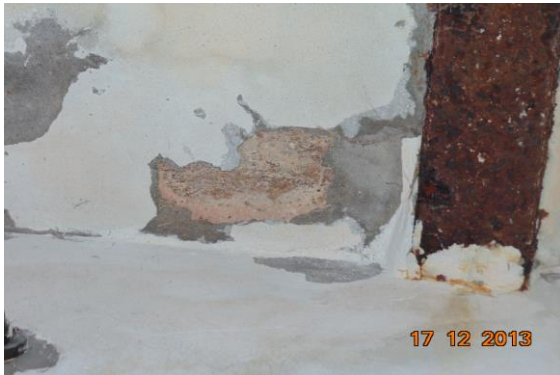
Photo 38

Peeling of Plaster on Roof of Shop No.129 of Ground Floor

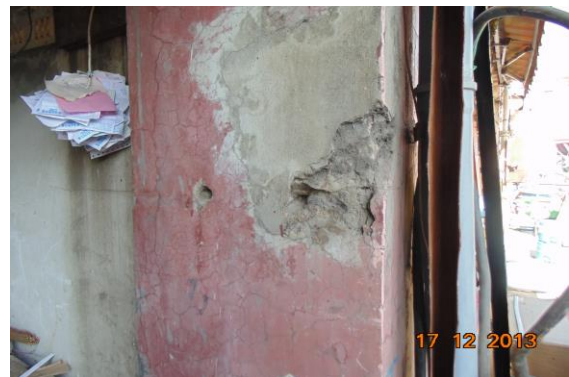
Photo 41

Damaged Portion on Floor of Shop No.129 of Ground Floor

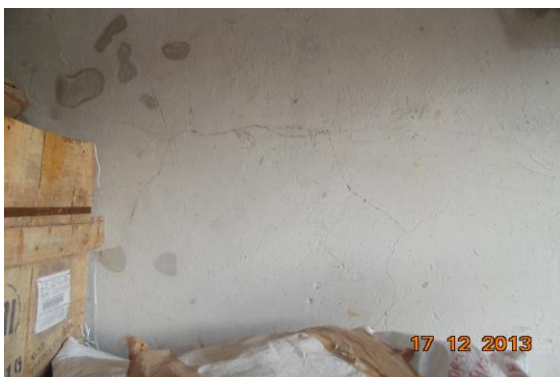
Photo 42

Damaged Portion on Wall No. 2 of Shop No.130 of Ground Floor

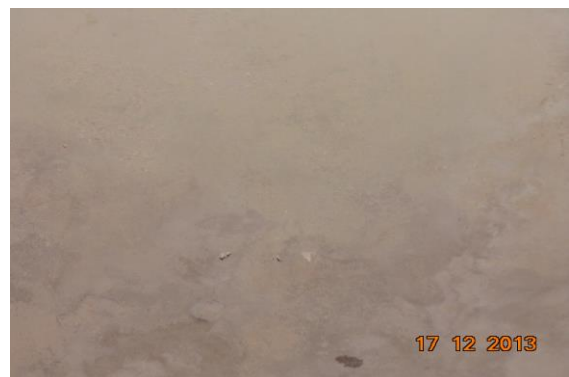
Photo 43

Peeling of Plaster on Wall No. 2 of Shop No.130 of Ground Floor

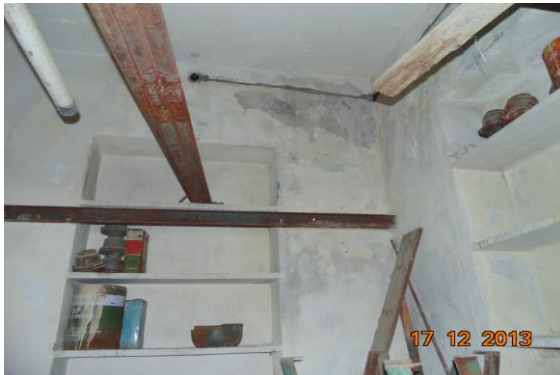
Photo 44

Dampness/Seepage on Roof of Shop No.130 of Ground Floor

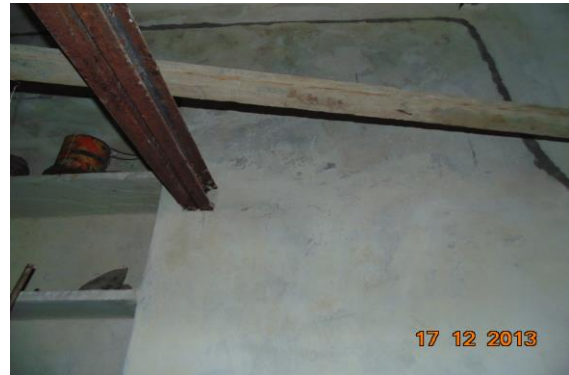
Photo 45

Dampness/Seepage on Wall No. 4 of Shop No.130 of Ground Floor

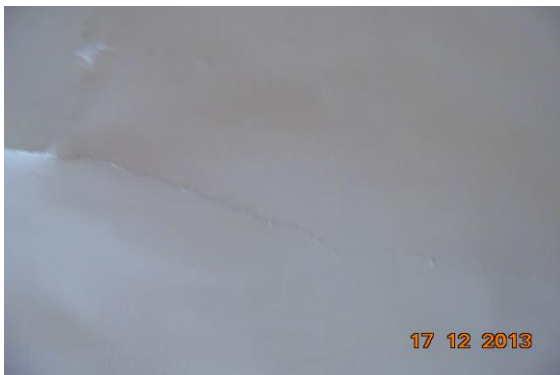
Photo 46

Dampness/Seepage on Wall No. 2 of Shop No.130 of Ground Floor

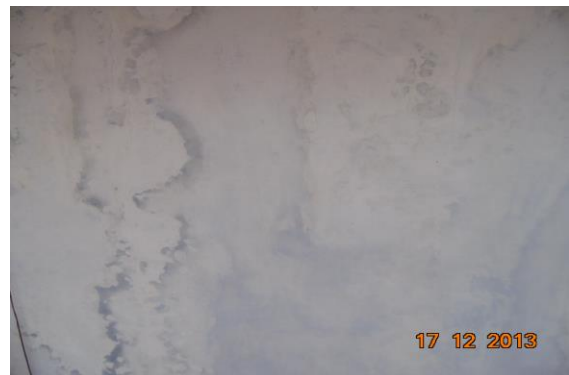
Photo 47

Peeling of Plaster on Roof of Shop No.127 of M/S/F

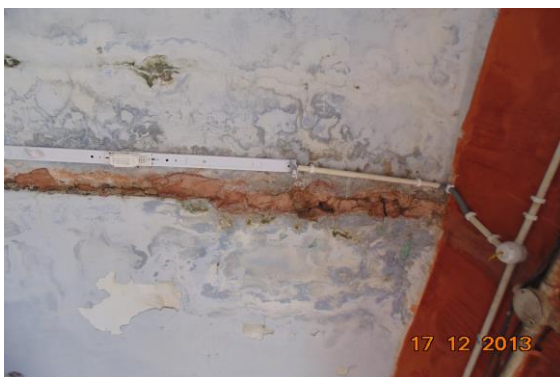
Photo 48

Dampness/Seepage on Roof of Varanda of Shop No.57 of Ground Floor

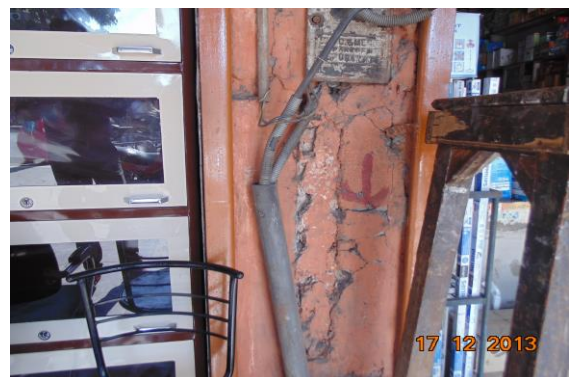
Photo 49

Damaged Portion on Roof of Varanda of Shop No.57 of Ground Floor

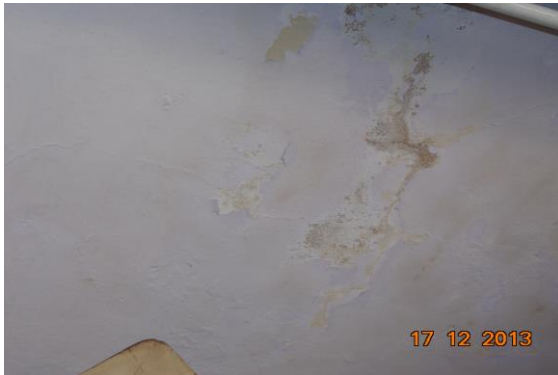
Photo 50

Damaged Portion on Outer Wall No.3 of Shop No.57 of Ground Floor

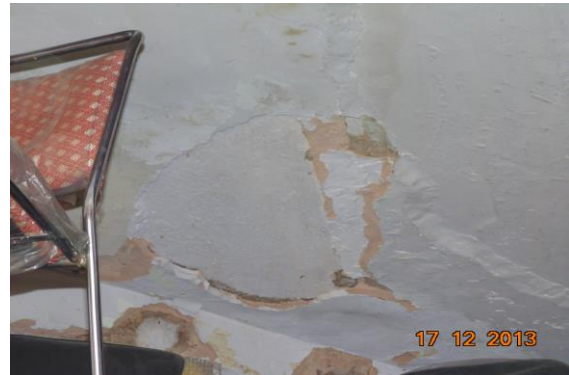
Photo 51

Peeling of Plaster on Roof of Shop No.57 of Ground Floor

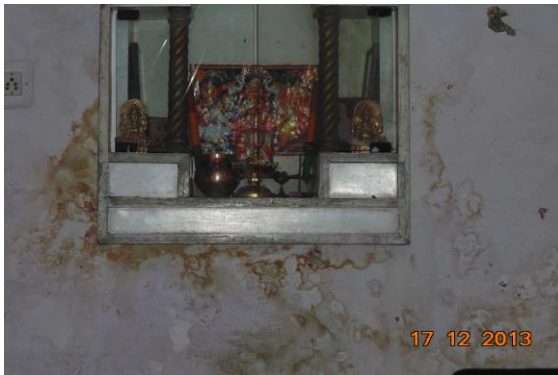
Photo 52

Damaged Portion on Roof of Shop No.57 of Ground Floor

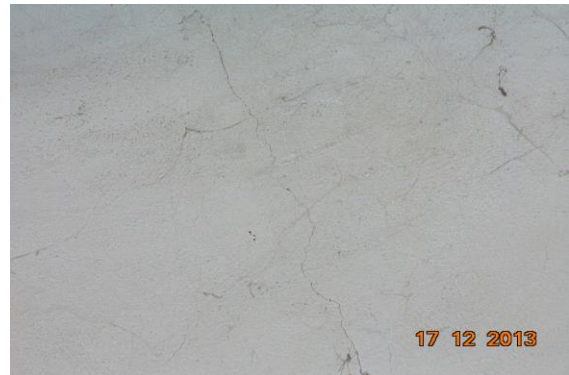
Photo 53

Dampness/Seepage on Wall No. 4 of Shop No.57 of Ground Floor

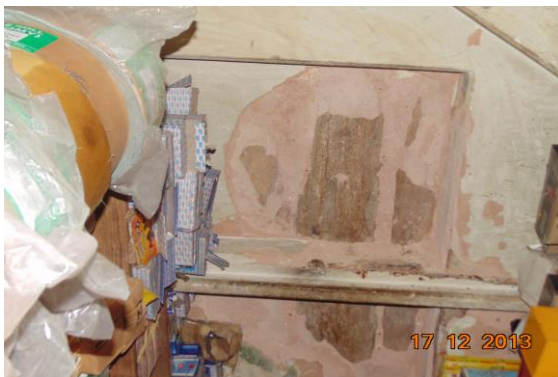
Photo 54

Peeling of Plaster on Roof of Shop No.84 of Ground Floor

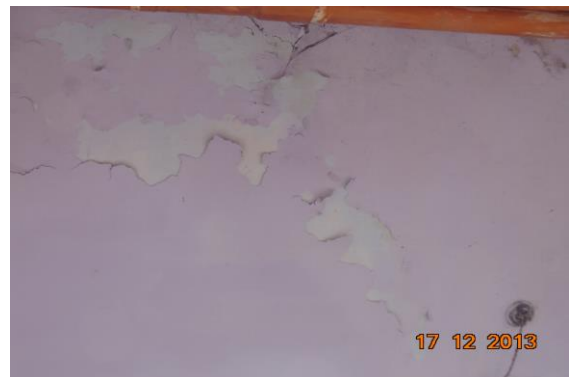
Photo 55

Dampness/Seepage on Roof of Shop No.84 of Ground Floor

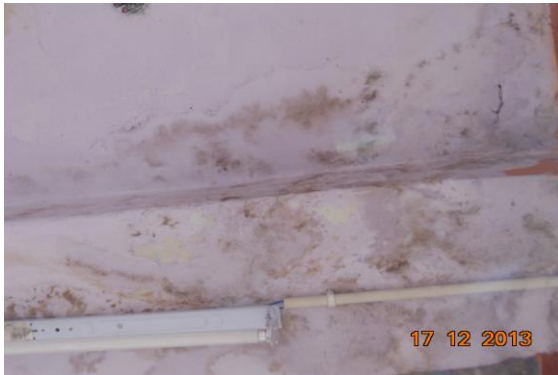
Photo 56

Peeling of Plaster on Roof of Varanda of Shop No.85 of Ground Floor

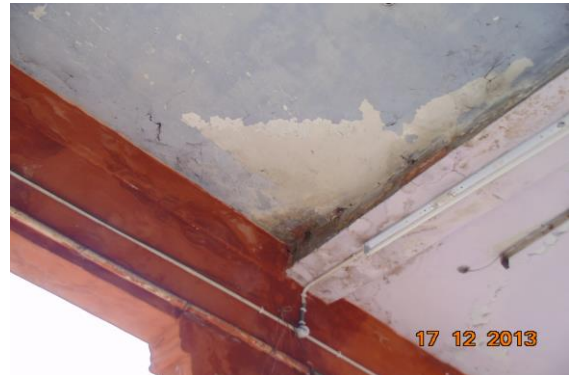
Photo 57

Dampness/Seepage on Roof of Varanda of Shop No.85 of Ground Floor

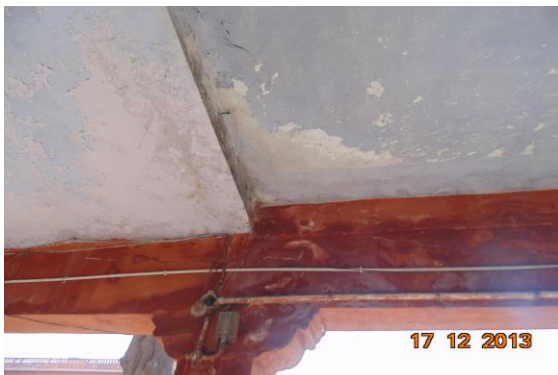
Photo 58

Dampness/Seepage on Roof & Beam of Varanda of Shop No.86 of Ground Floor

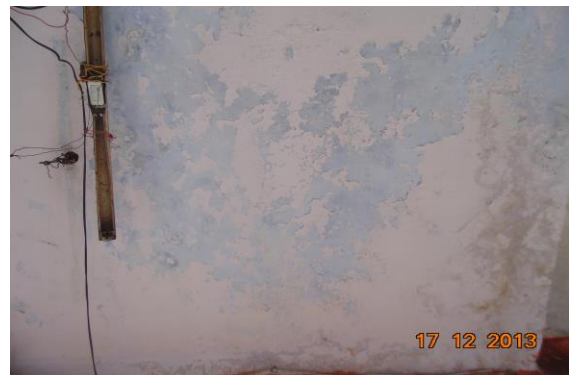
Photo 59

Dampness/Seepage on Roof & Beam of Varanda of Shop No.86 of Ground Floor

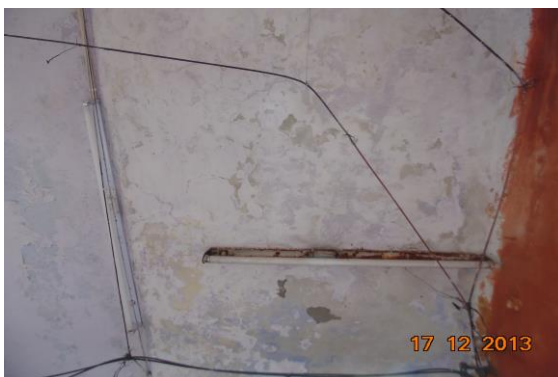
Photo 60

Peeling of Plaster on Roof of Shop No.87 A of Ground Floor

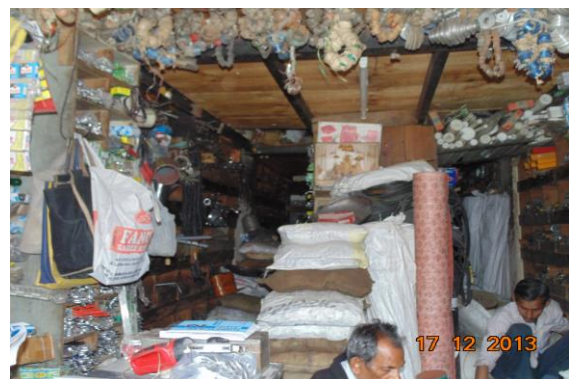
Photo 86
Wall No. 4 of Shop No.84 of Ground Floor Covered With Material

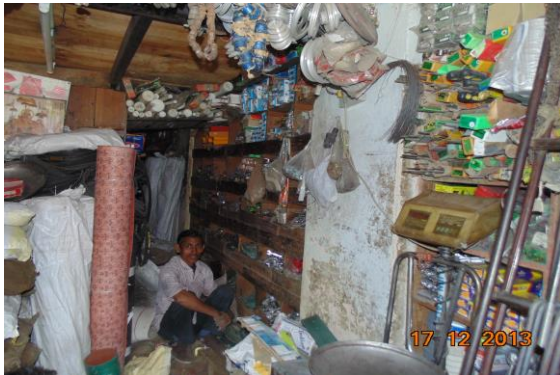
Photo 87

Wall No. 2 of Shop No.84 of Ground Floor Covered With Material

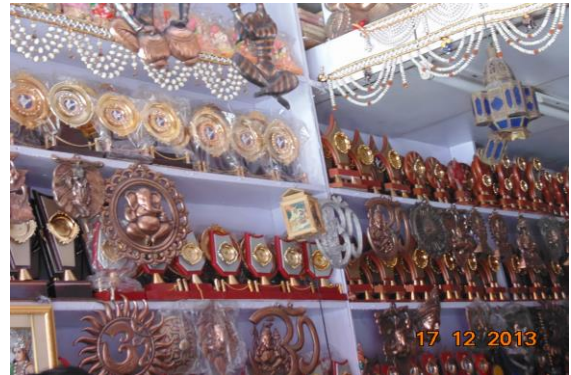
Photo 88

Wall No. 1 of Shop No.85 of Ground Floor Covered With Material

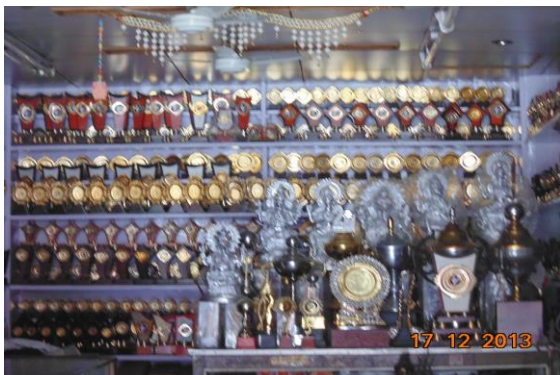
Photo 89

Wall No. 4 of Shop No.85 of Ground Floor Covered With Material

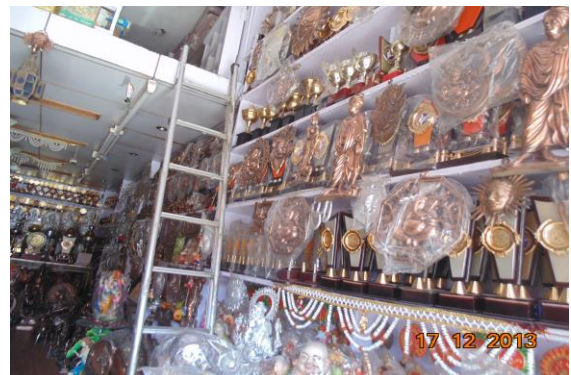
Photo 90

Wall No. 2 of Shop No.85 of Ground Floor Covered With Material

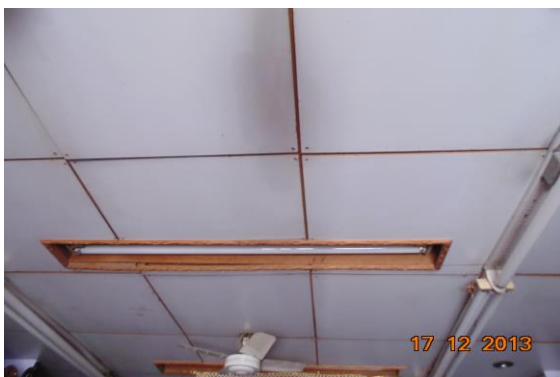
Photo 91

Roof of Shop No.85 of Ground Floor Covered With Wooden Work

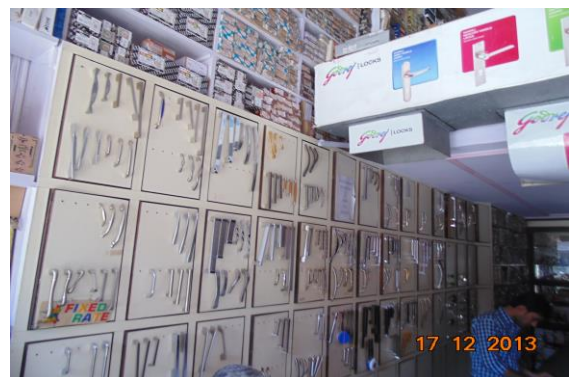
Photo 92

Wall No. 1 of Shop No.86 of Ground Floor Covered With Material

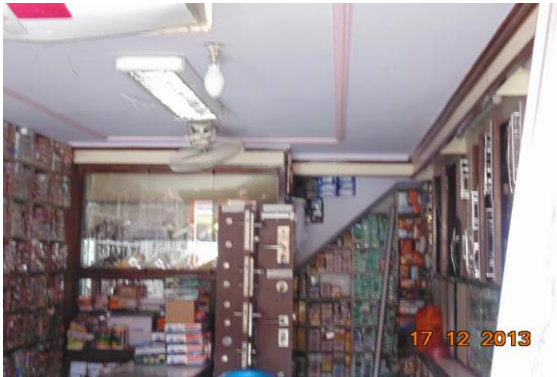
Photo 93

Wall No. 4 of Shop No.86 of Ground Floor Covered With Material

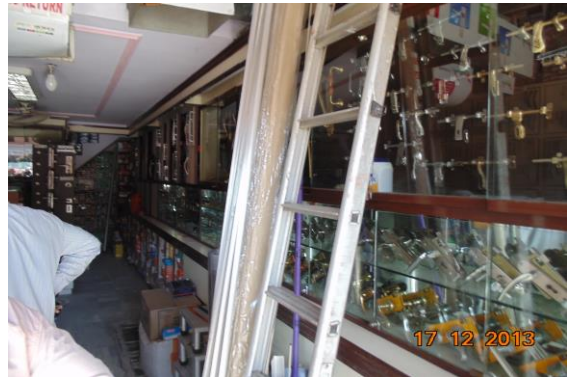
Photo 94

Wall No. 2 of Shop No.86 of Ground Floor Covered With Material

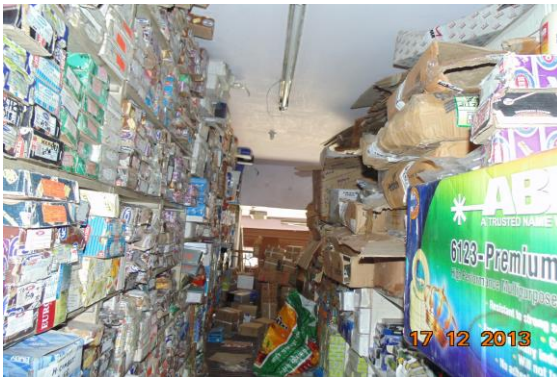
Photo 95

All Walls of Shop No.86 of upper Ground Floor Covered With Material

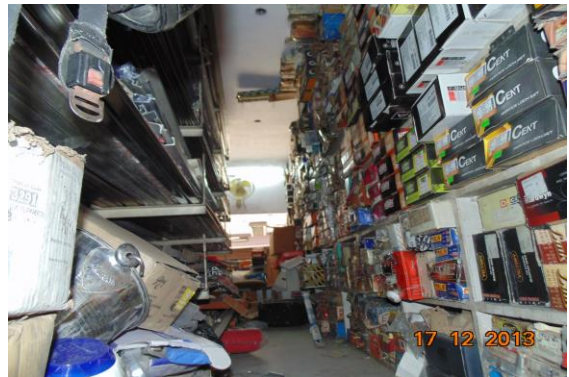
Photo 96

All Walls of Shop No.86 of upper Ground Floor Covered With Material

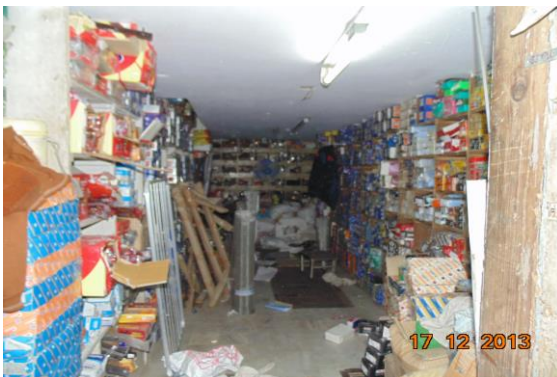
Photo 97

All Walls of Shop No.86 of Basement No.1 Covered With Material

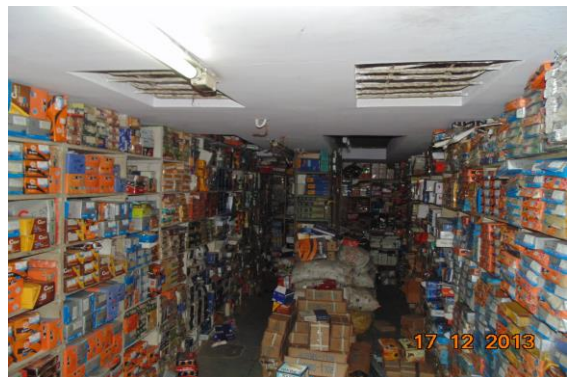
Photo 98

All Walls of Shop No.86 of Basement No.2 Covered With Material

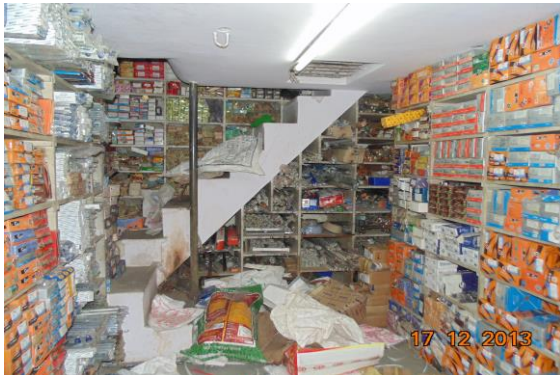
Photo 99

All Walls of Shop No.86 of Basement No.2 Covered With Material

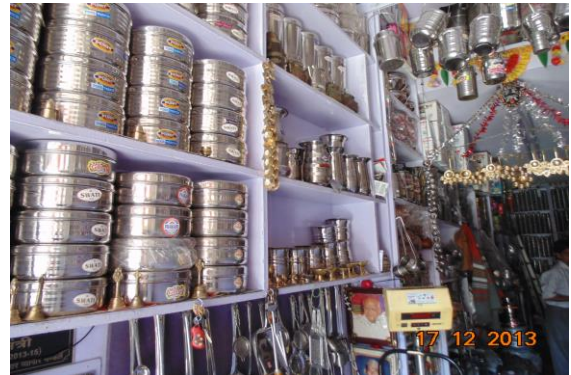
Photo 100

Wall No. 1 of Shop No.87 A of Ground Floor Covered With Material

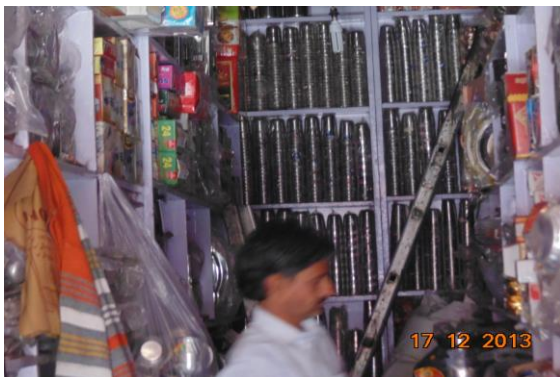
Photo 101

Wall No. 4 of Shop No.87 A of Ground Floor Covered With Material

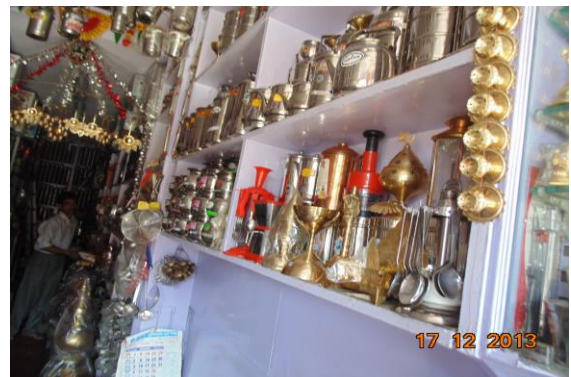
Photo 102

Wall No. 2 of Shop No.87 A of Ground Floor Covered With Material

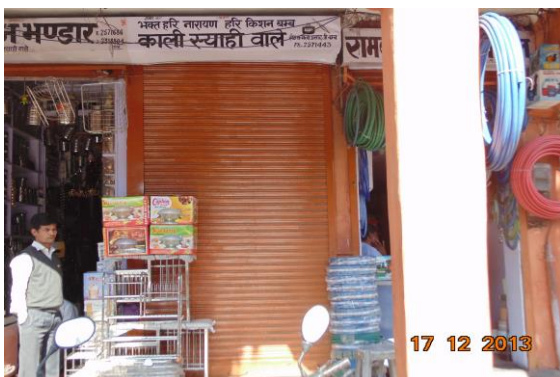
Photo 103

Shop No.87 B of Ground Floor Locked

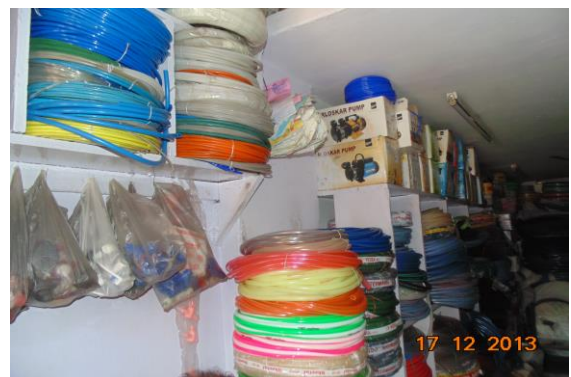
Photo 104

Wall No. 1 of Shop No.88 of Ground Floor Covered With Material

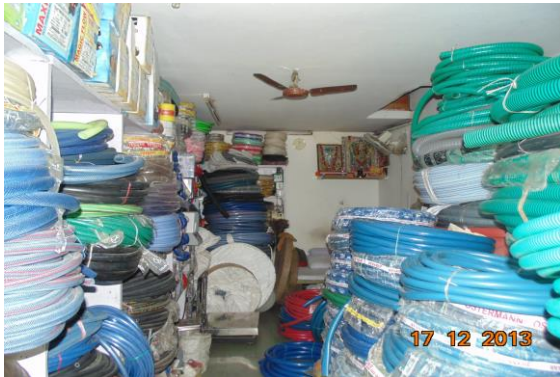
Photo 105

Wall No. 4 of Shop No.88 of Ground Floor Covered With Material

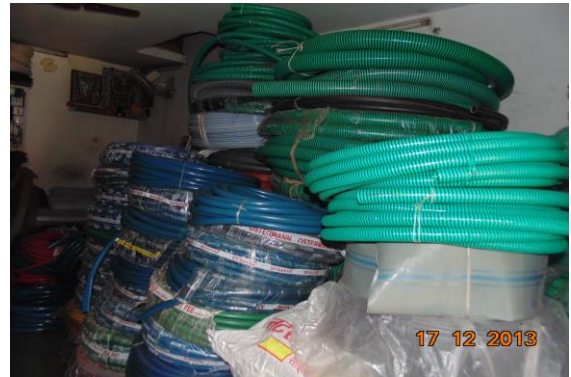
Photo 106

Wall No. 2 of Shop No.88 of Ground Floor Covered With Material

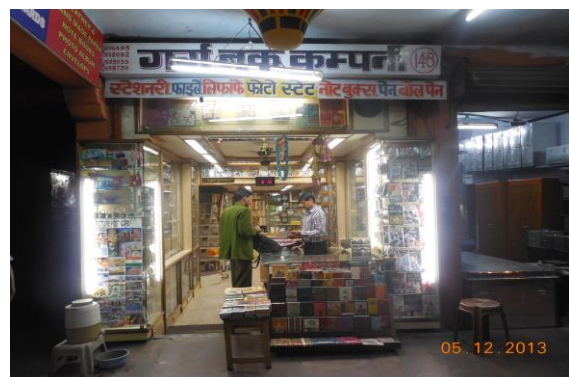
Photo 18
View of shop No.148, Ground Floor

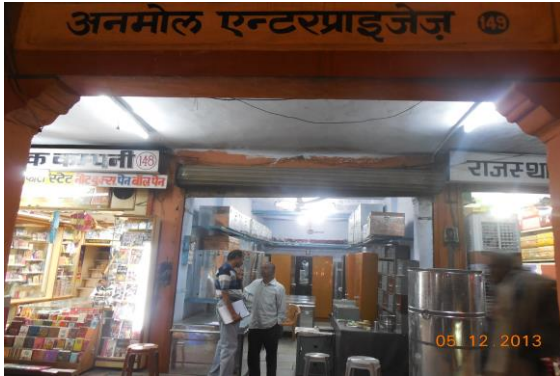
Photo 19
View of shop No.149, Ground Floor

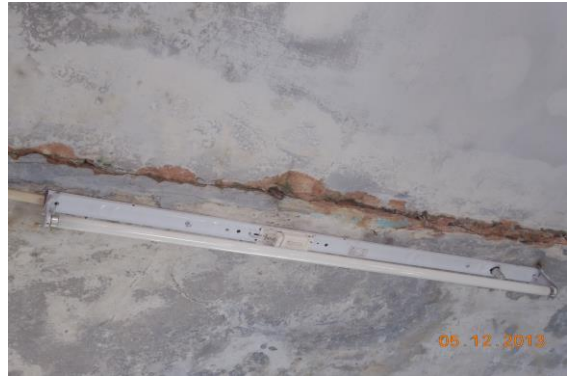
Photo 20
Horizontal Crack on Roof of Varanda of Shop, Ground Floor Approx.
Width = 10mm, Approx. Length = 2.9m. Distance from Leftside External
Column = 0m, Height from Floor = 3.9m.

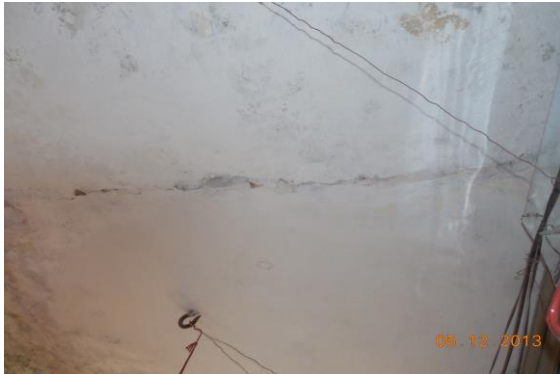
Photo 21
Horizontal Crack on Roof of Varanda of Shop, Ground Floor Approx.
Width = 0.8mm, Approx. Length = 2.9m. Distance from Leftside External
Column = 1.5m, Height from Floor = 3m.

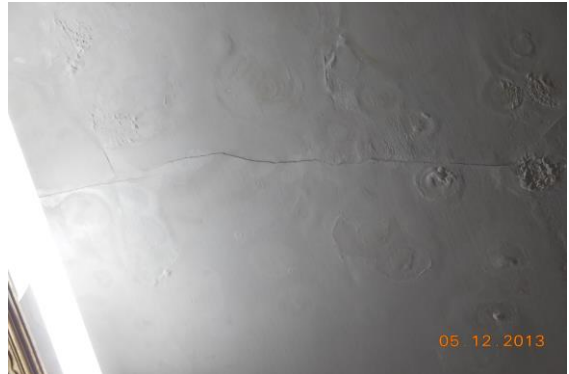
Photo 22
Horizontal Crack on Roof of Shop No.138, Ground Floor Approx. Width
= 0.35mm, Approx. Length = 3.3m. Distance from Wall No.3 = 4m,
Height from Floor = 3m.

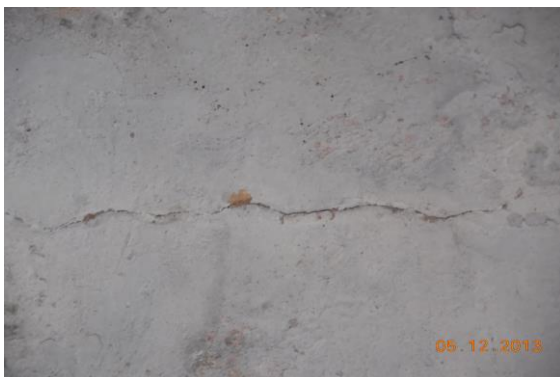
Photo 23
Inclined Crack on Roof of Varanda of Shop, Ground Floor Approx. Width
= 0.3mm, Approx. Length = 2.9m. Distance from Leftside External
Column = 1.1m, Height from Floor = 3m.

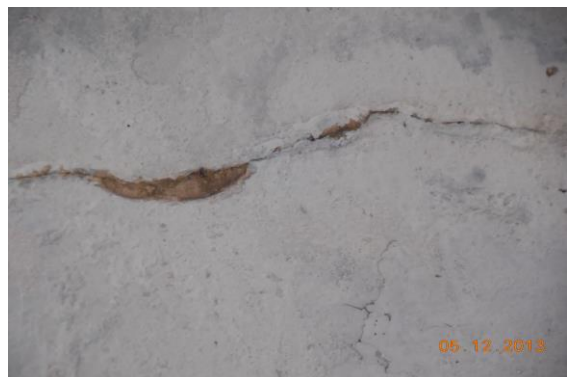
Photo 24
Inclined Crack on Roof of Varanda of Shop, Ground Floor Approx. Width
= 0.3mm, Approx. Length = 2.9m. Distance from Leftside External
Column = 1.3m, Height from Floor = 3m.

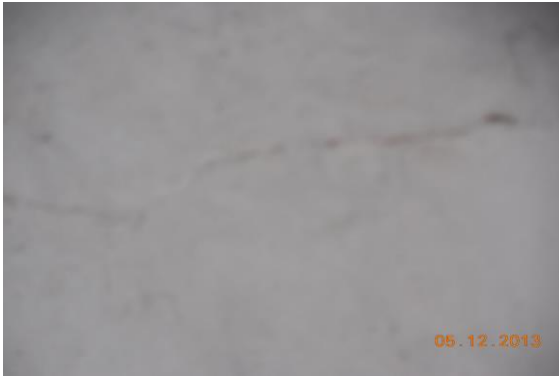
Photo 25

Inclined Crack on Roof of Varanda of Shop, Ground Floor Approx. Width = 0.3mm, Approx. Length = 2.9m. Distance from Leftside External Column = 1.5m, Height from Floor = 3m.

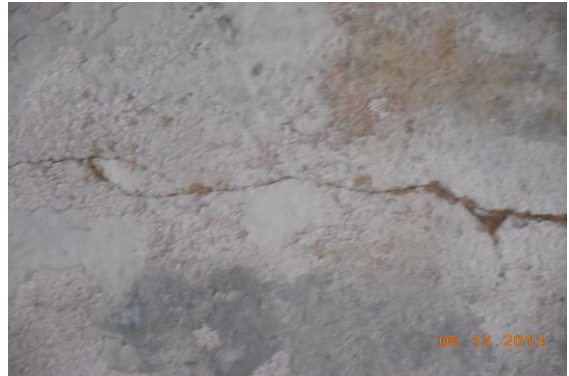
Photo 26

Inclined Crack on Roof of Varanda of Shop, Ground Floor Approx. Width = 0.4mm, Approx. Length = 2.9m. Distance from Rightside External Column = 0.1m, Height from Floor = 3m.

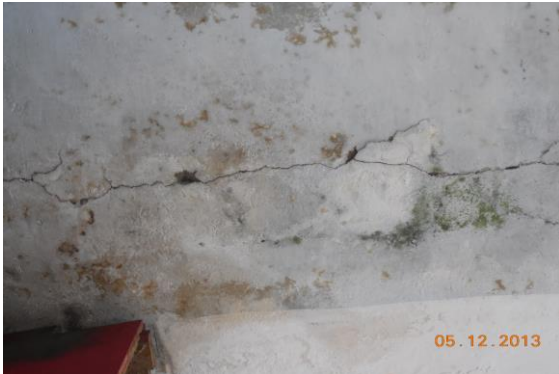
Photo 27

Inclined Crack on Roof of Varanda of Shop, Ground Floor Approx. Width = 0.6mm, Approx. Length = 3.9m. Distance from Rightside External Column = 0m, Height from Floor = 3m.

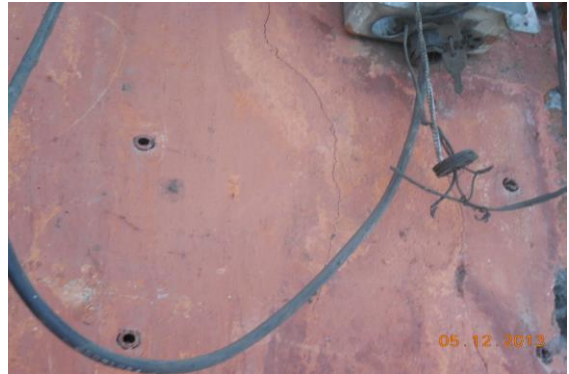
Photo 27A

Inclined Crack on Roof of Varanda of Shop, Ground Floor Approx. Width = 0.6mm, Approx. Length = 3.9m. Distance from Rightside External Column = 0m, Height from Floor = 3m.

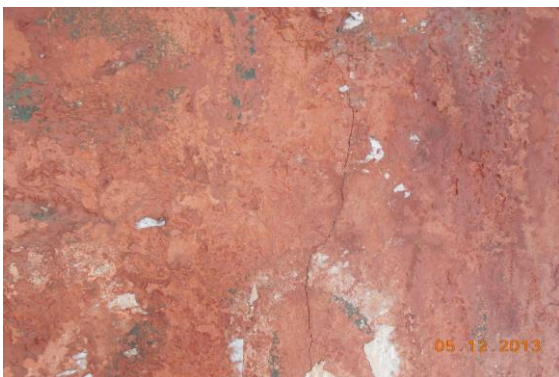
Photo 28

Inclined Crack on Wall No. Right Column of Varanda of Shop, Ground Floor Approx. Width = 0.5mm, Approx. Length = 1m. Distance from Wall No.2 = 0.4m, Height from Floor = 1.3m.

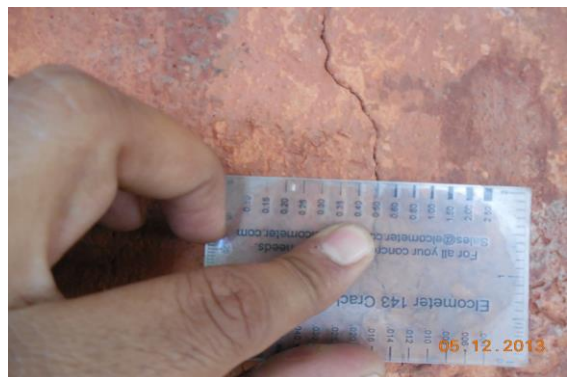
Photo 28A

Inclined Crack on Wall No. Right Column of Varanda of Shop, Ground Floor Approx. Width = 0.5mm, Approx. Length = 1m. Distance from Wall No.2 = 0.4m, Height from Floor = 1.3m.

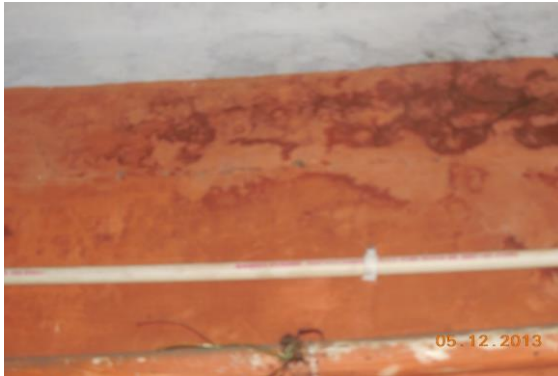
Photo 29

Inclined Crack on Wall No. 1 of Staircase GF to Basement, Basement
Approx. Width = 0.8mm, Approx. Length = 1.3m. Distance from Leftside
External Column = 0m, Height from Floor = 2.9m.

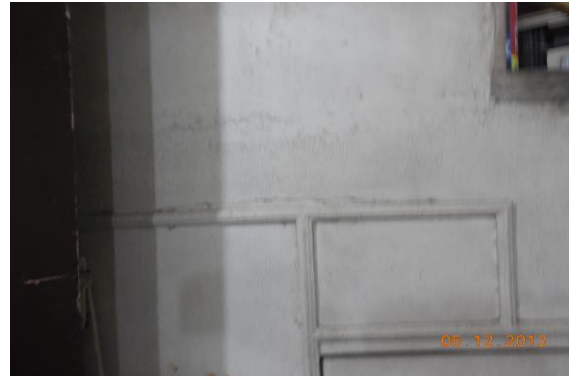
Photo 30

Inclined Crack on Wall No. 1 of Staircase GF to Basement, Basement
Approx. Width = 0.25mm, Approx. Length = 0.5m. Distance from Wall
no.3 = 0m, Height from Floor = 1.3m.

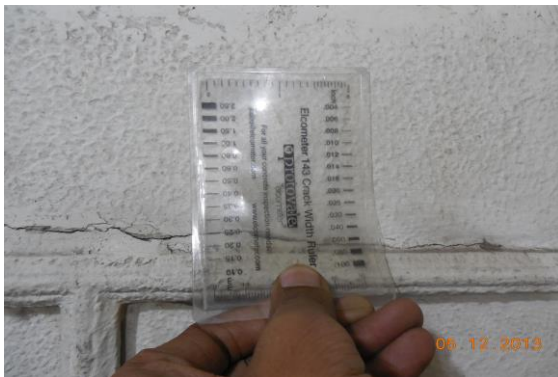
Photo 30A

Inclined Crack on Wall No. 1 of Staircase GF to Basement, Basement
Approx. Width = 0.25mm, Approx. Length = 0.5m. Distance from Wall
no.3 = 0m, Height from Floor = 1.3m.

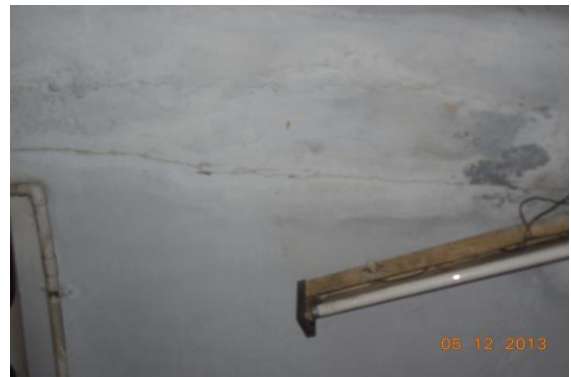
Photo 31

Horizontal Crack on Roof of Varanda of Shop, Ground Floor Approx.
Width = 0.6mm, Approx. Length = 2.9m. Distance from Leftside External
Column = 0m, Height from Floor = 3m.

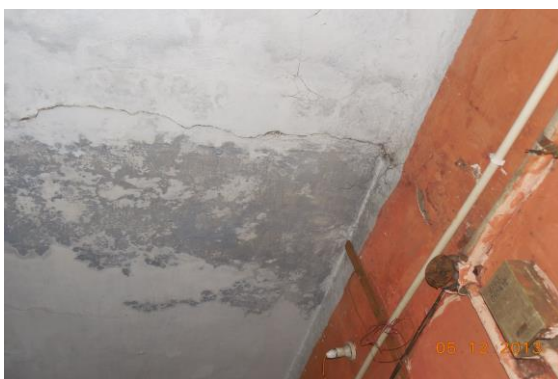
Photo 32

Inclined Crack on Roof of Varanda of Shop, Ground Floor Approx. Width
= 5mm, Approx. Length = 2.9m. Distance from Right side External
Column = 0m, Height from Floor = 3m.

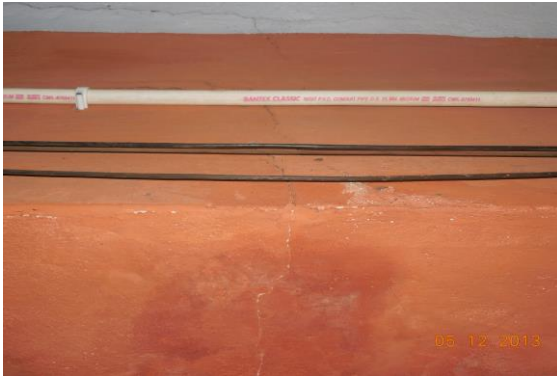
Photo 33A

Inclined Crack on Outer Beam of Varanda of Shop, G/F Approx. Width = 2.5mm, Approx. Length = 2.9m. Distance from Leftside External Column = 0.4m, Height from Floor = 2.4m.

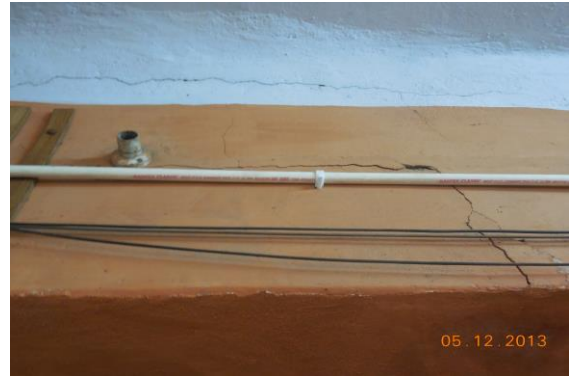
Photo 33A

Inclined Crack on Outer Beam of Varanda of Shop, Ground Floor Approx. Width = 2.5mm, Approx. Length = 2.9m. Distance from Leftside External Column = 0.4m, Height from Floor = 2.4m.

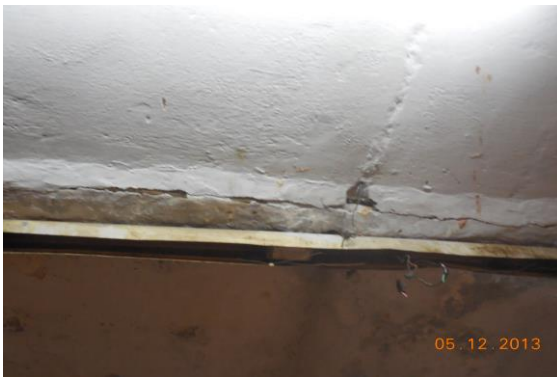
Photo 34

Horizontal Crack on Roof of Varanda of Shop, Ground Floor Approx. Width = 1mm, Approx. Length = 3.3m. Distance from Leftside External Column = 0m, Height from Floor = 2.4m.

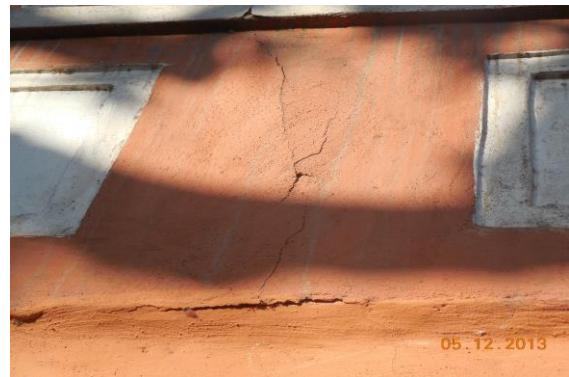
Photo 35

Peeling of Plaster on Wall No. Leftside External Column of Varanda of Shop of Ground Floor

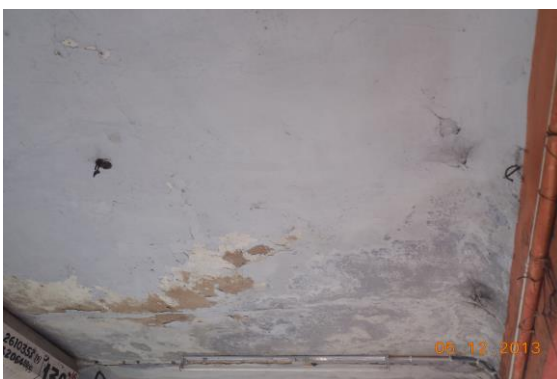
Photo 36

Dampness/Seepage on Roof of Varanda of Shop of Ground Floor

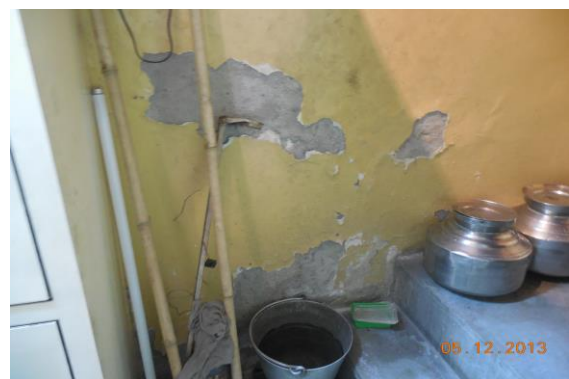
Photo 37

Peeling of Plaster on Wall No. 4 of Staircase of Upper Ground Floor

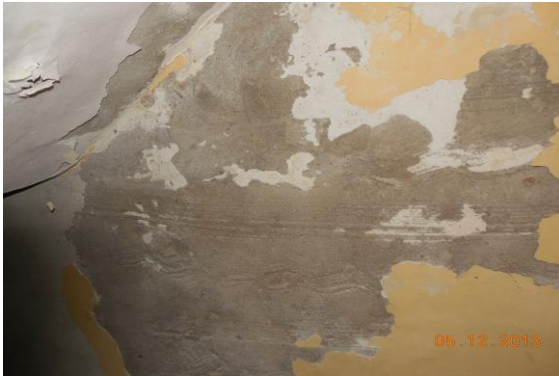
Photo 38

Peeling of Plaster on Wall No. 4 of Staircase of Basement

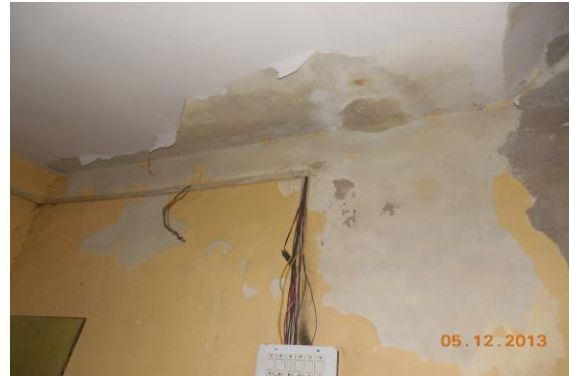
Photo 39

Dampness/Seepage on Wall No. 2 of Staircase of Basement

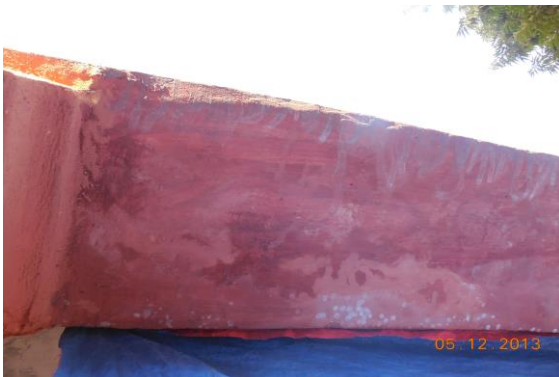
Photo 40

Dampness/Seepage on External Beam of Varanda of Shop of Ground Floor

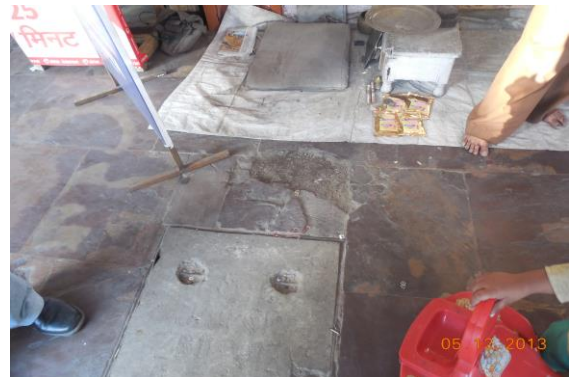
Photo 41

Peeling of Plaster on Floor of Varanda of Shop of Ground Floor

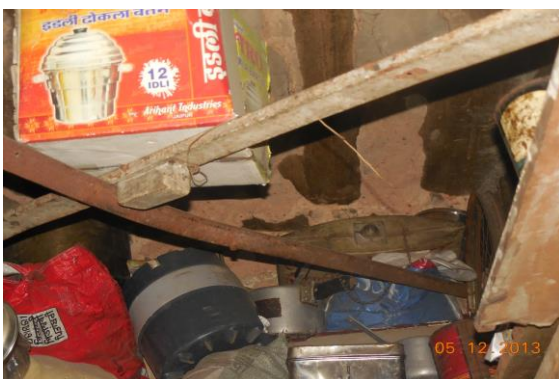
Photo 42

Peeling of Plaster on Wall No. 4 & Roof of Part C of Shop of Ground Floor

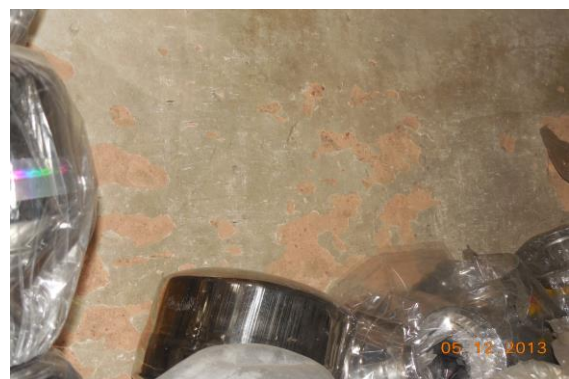
Photo 43

Peeling of Plaster on Wall No. 1 of Part C of Shop of Ground Floor

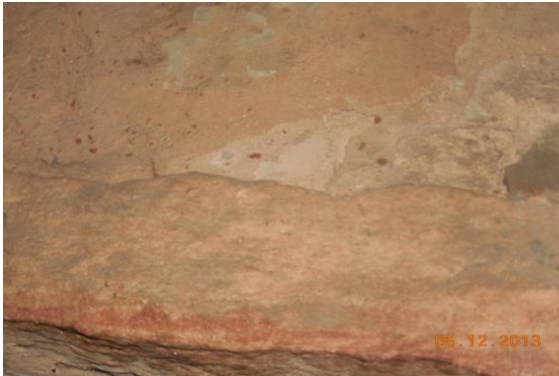
Photo 44

Peeling of Plaster on Wall No. 3 of Part C of Shop of Ground Floor
