Pre Building Condition Survey Report

Name and Address of Structure :	Choti Chopar to Badi Chopar (UP Line)
---------------------------------	---------------------------------------

Name of the Project	Contract JMRC-UG1B “Design and Construction of Tunnel between Chandpole and Badi Chouper and reverse line by Shield TBM, Underground Metro Stations at Choti Chouper and Badi Chouper by Cut and Cover Methods on East West Corridor of Jaipur Metro Rail Corporation Limited .”	
Owner :

Shoping Complex - Shop No. 169-188
Tripolia Bazar
Jaipur
Unique ID: CC BC UP 0001

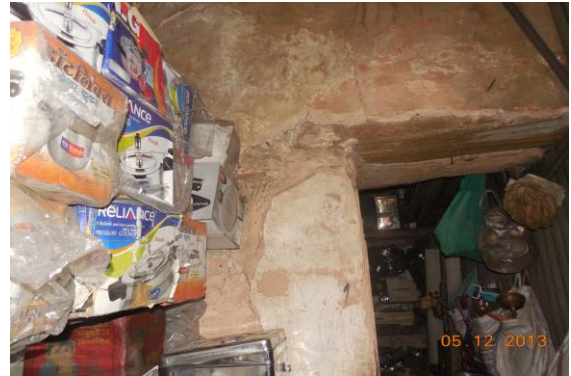
Photo 45

Peeling of Plaster on Wall No. 4 of Part B of Shop of Ground Floor

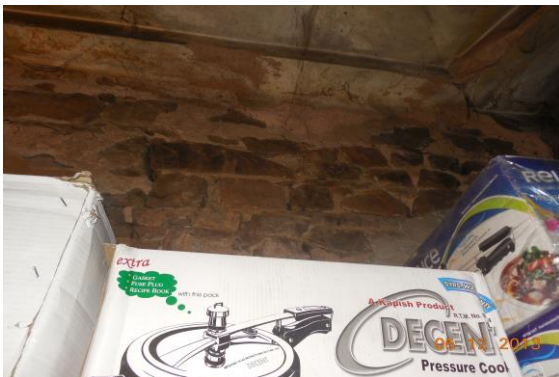
Photo 46

Peeling of Plaster on Wall No. 1 of Part B of Shop of Ground Floor

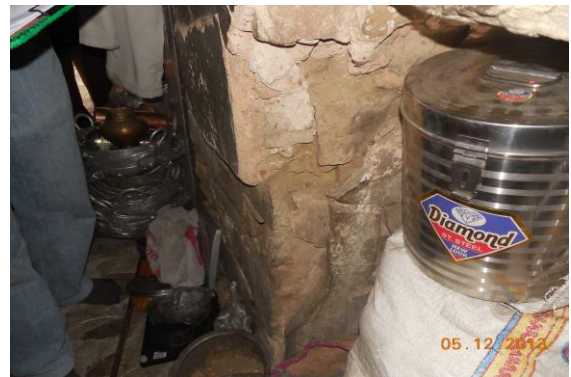
Photo 47

Peeling of Plaster on Wall No. 3 of Part B of Shop of Ground Floor

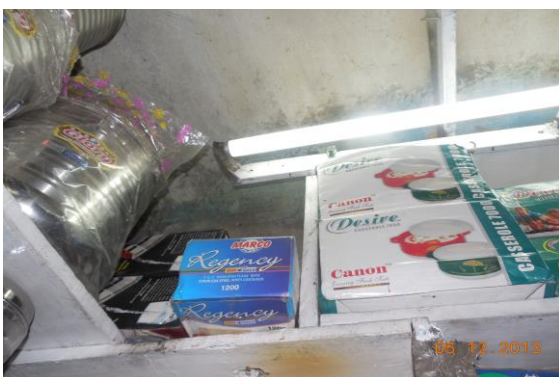
Photo 48

Dampness/Seepage on Roof of Part A of Shop of Ground Floor

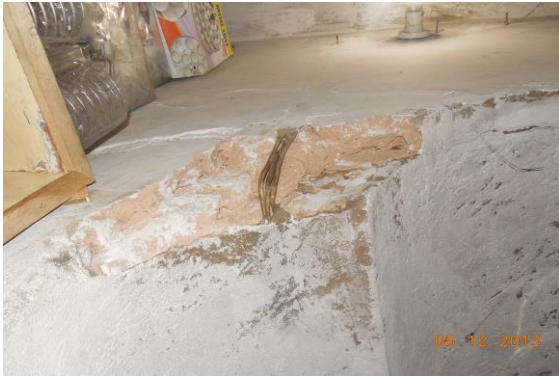
Photo 50

Peeling of Plaster on Wall No. 3 of Part B of Shop of Ground Floor

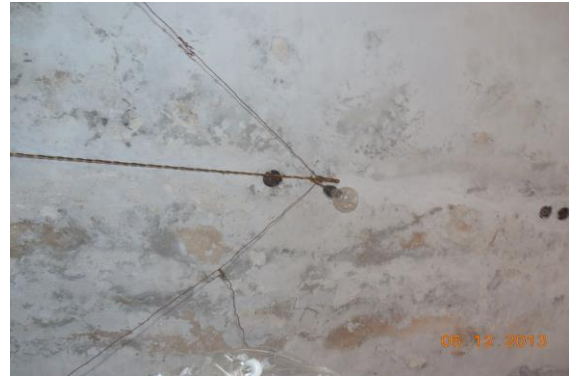
Photo 51

Dampness/Seepage on Roof of Varanda of Shop of Ground Floor

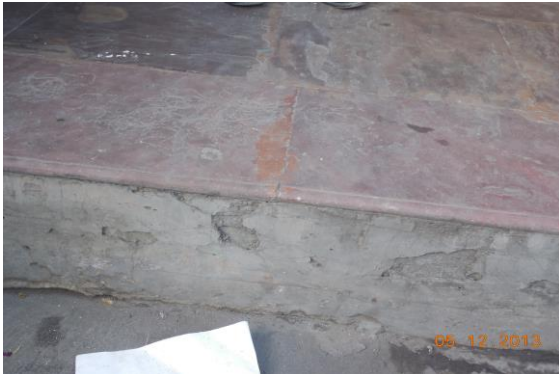
Photo 52

Peeling of Plaster on Floor & of Varanda of Shop of Ground Floor

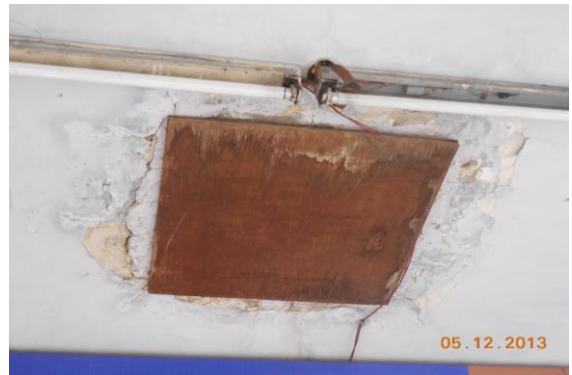
Photo 53

Peeling of Plaster on Roof of Varanda of Shop of Ground Floor

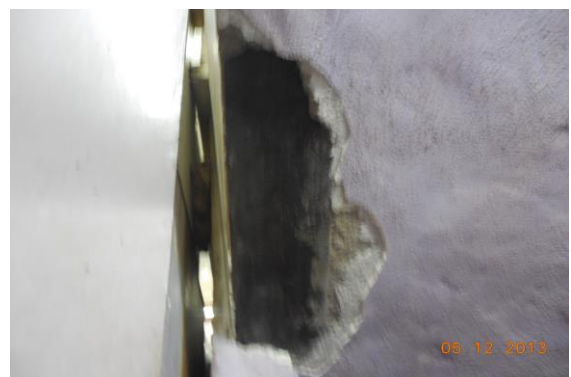
Photo 54

Dampness/Seepage on Roof of Varanda of Shop of Ground Floor

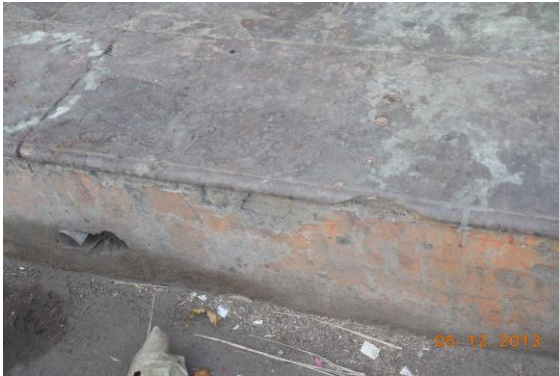
Photo 56
Peeling of Plaster on Floor of Varanda of Shop of Ground Floor

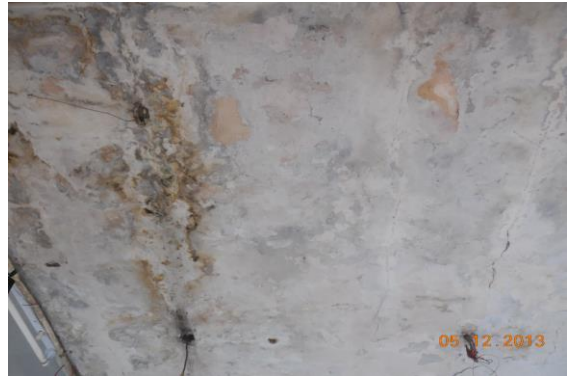
Photo 57
Dampness/Seepage on Roof of Varanda of Shop of Ground Floor

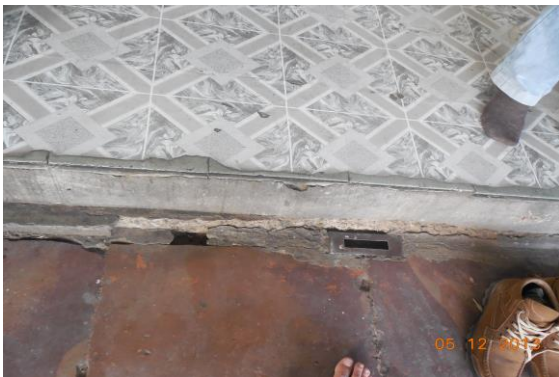
Photo 58
Peeling of Plaster on Floor of Shop No.139 of Ground Floor

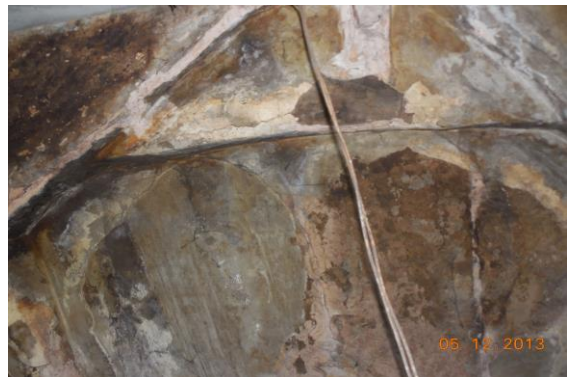
Photo 59
Peeling of Plaster on Roof of Part B of Shop of Ground Floor

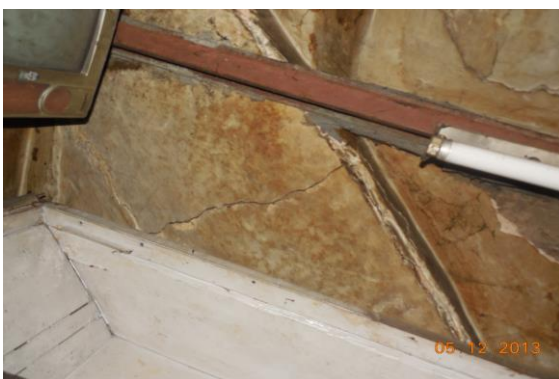
Photo 60
Peeling of Plaster on Roof of Part B of Shop of Ground Floor

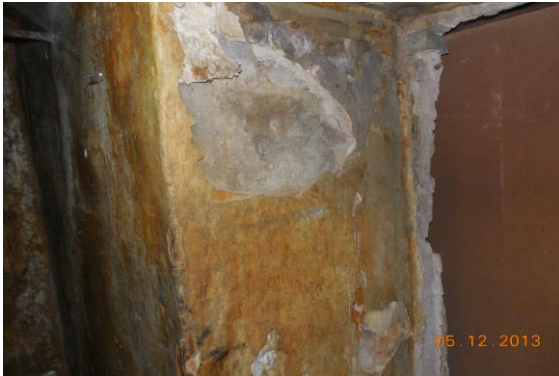
Photo 62

Peeling of Plaster on Entry Gate Right Side of Part C of Shop of Ground Floor

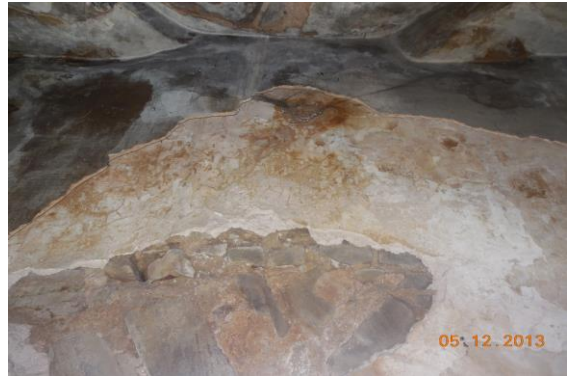
Photo 63

Peeling of Plaster on Wall No. 3 of Part C of Shop of Ground Floor

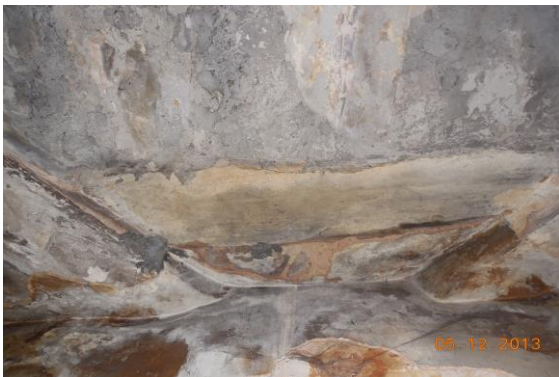
Photo 64

Peeling of Plaster on Roof of Part C of Shop of Ground Floor

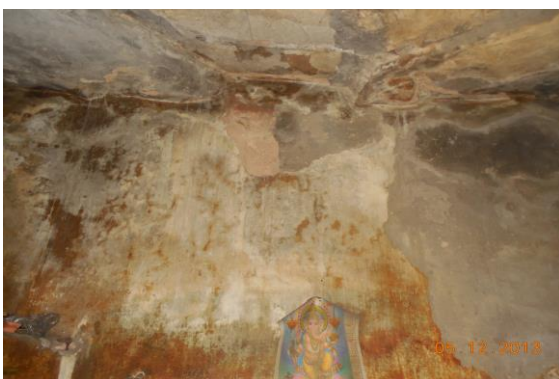
Photo 66

Dampness/Seepage on Wall No. 4 of Part C of Shop of Ground Floor

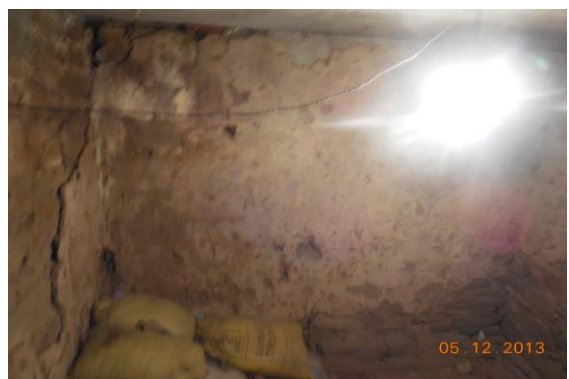
Photo 67

Peeling of Plaster on Wall No. 1 of Shop No.139 of Basement

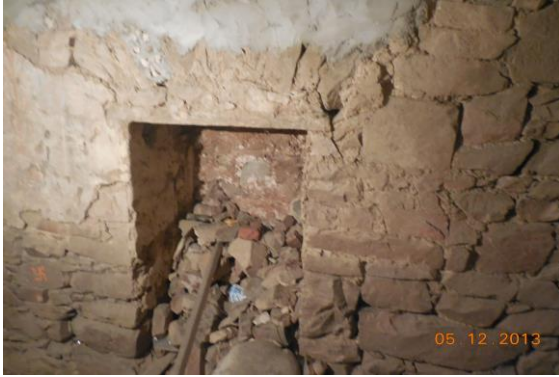
Photo 68

Peeling of Plaster on Wall No. 4 of Shop No.139 of Basement

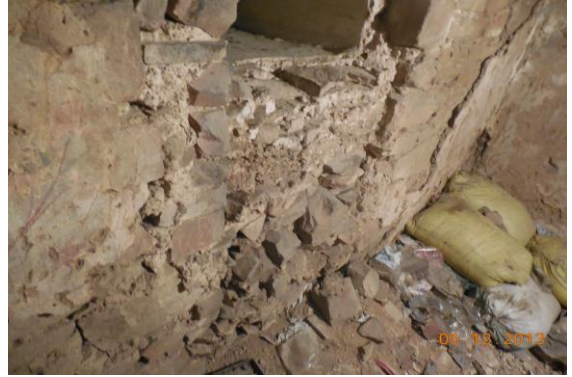
Photo 69

Peeling of Plaster on Wall No. 3 of Shop No.139 of Basement

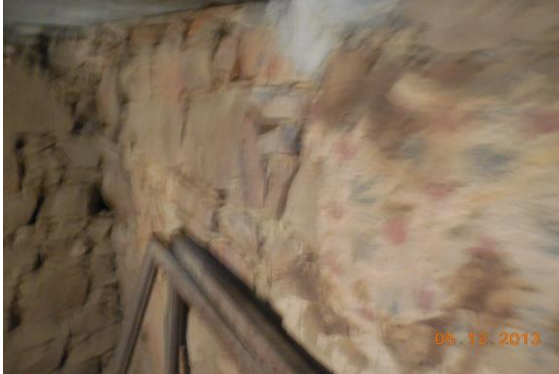
Photo 70

Peeling of Plaster on Wall No. 2 of Shop No.139 of Basement

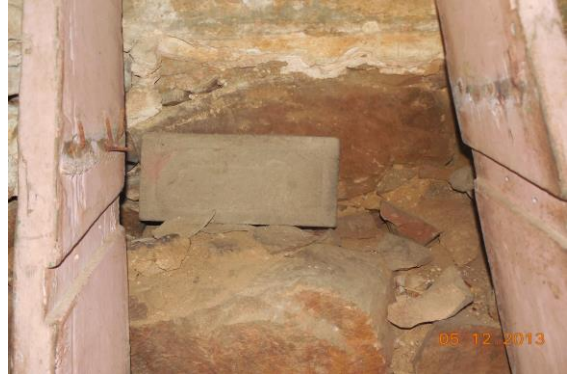
Photo 71

Peeling of Plaster on Wall No. 3 of Shop No.139 of Basement

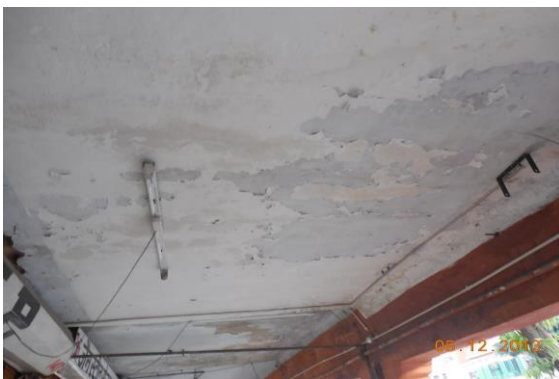
Photo 72

Dampness/Seepage on Roof of Varanda of Shop of Ground Floor

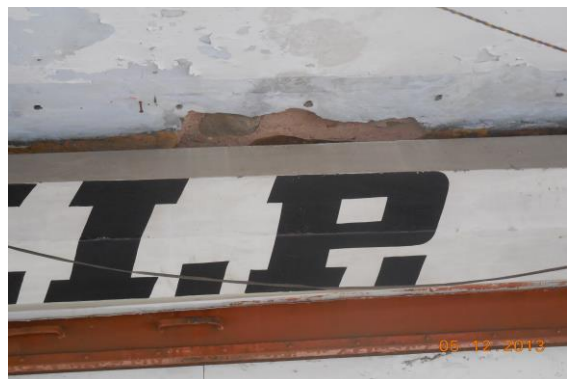
Photo 73

Peeling of Plaster on Outer wall No.3 of Varanda of Shop of Ground Floor

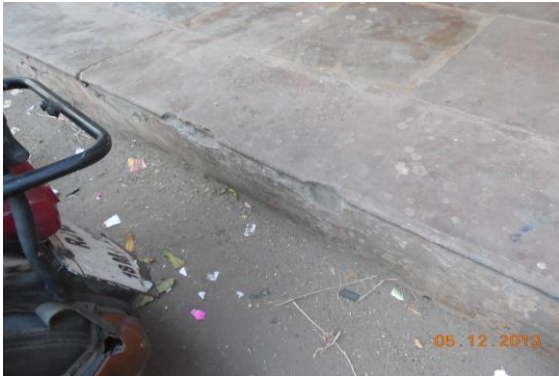
Photo 74

Peeling of Plaster on Floor & frontside of Varanda of Shop of Ground Floor

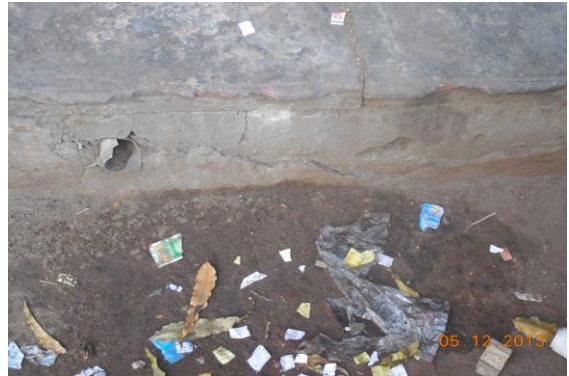
Photo 75

Peeling of Plaster on Floor & 3 of Varanda of Shop of Ground Floor

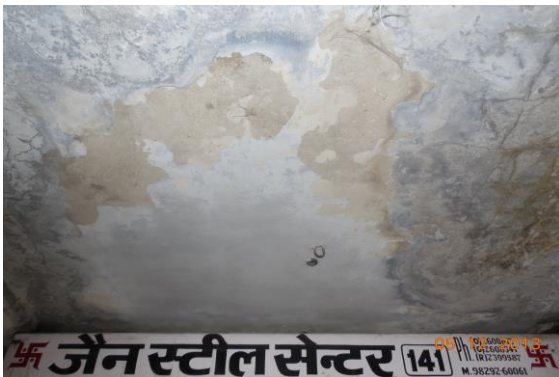
Photo 76

Dampness/Seepage on Roof of Varanda of Shop of Ground Floor

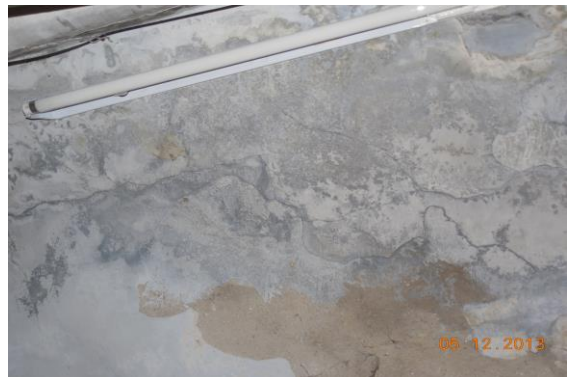
Photo 77

Peeling of Plaster on Roof of Varanda of Shop of Ground Floor

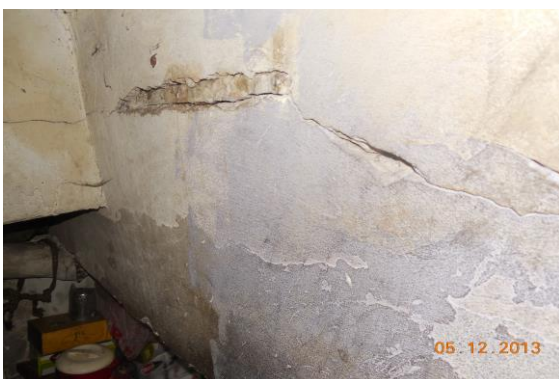
Photo 78

Peeling of Plaster on Wall No. 2 of Staircase of Basement

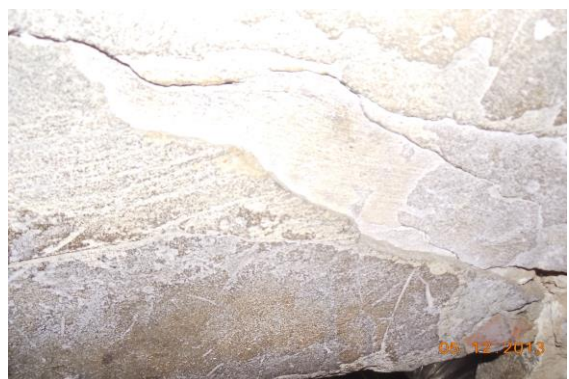
Photo 79

Peeling of Plaster on Wall No. 2 of Staircase of Basement

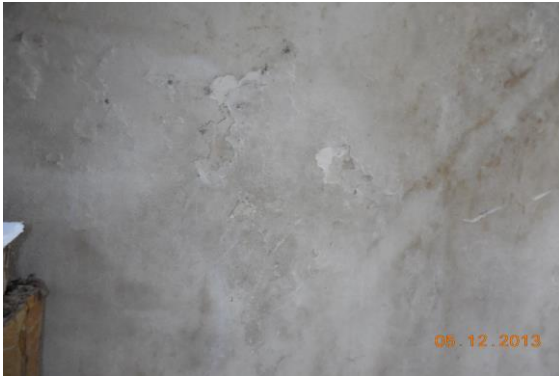
Photo 80

Peeling of Plaster on Wall No. 2 of Shop No.142 & 143 of Basement No.2

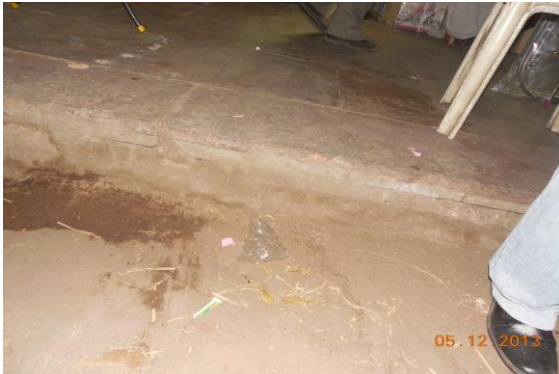
Photo 82

Peeling of Plaster on Floor & 3 of Varanda of Shop of Ground Floor

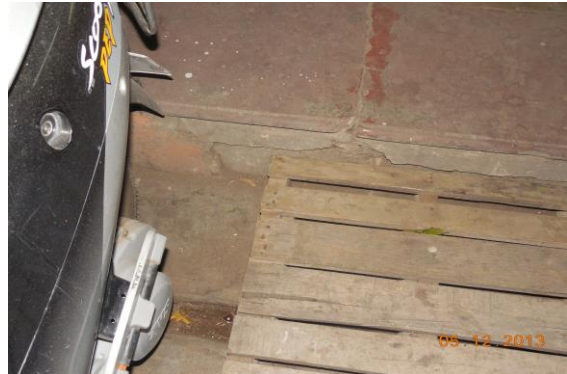
Photo 83

Peeling of Plaster on Floor & 1 of Varanda of Shop of Ground Floor

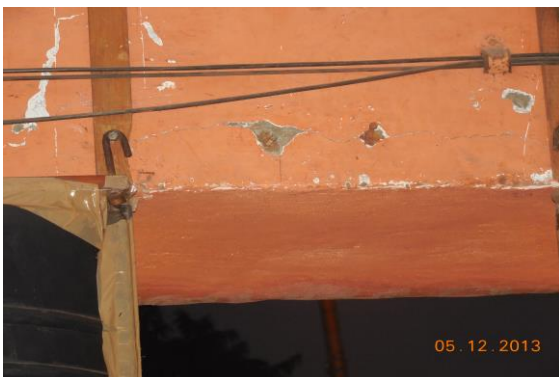
Photo 84

Peeling of Plaster on Beam of Varanda of Shop of Ground Floor

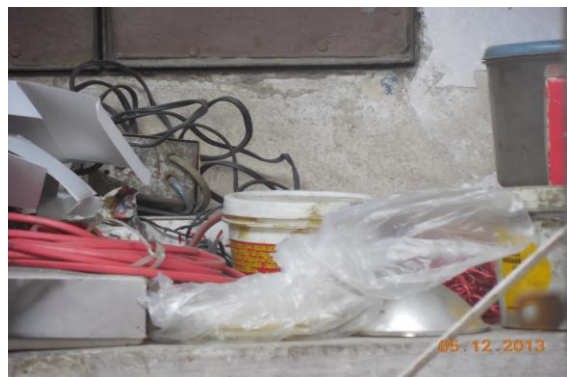
Photo 85

Peeling of Plaster on Wall No. 4 of Shop no.147 of Ground Floor

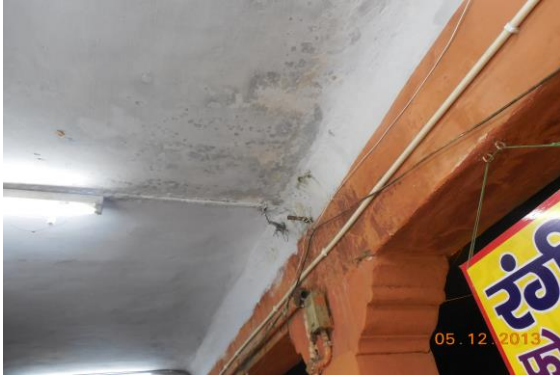
Photo 86

Dampness/Seepage on Roof of Varanda of Shop of Ground Floor

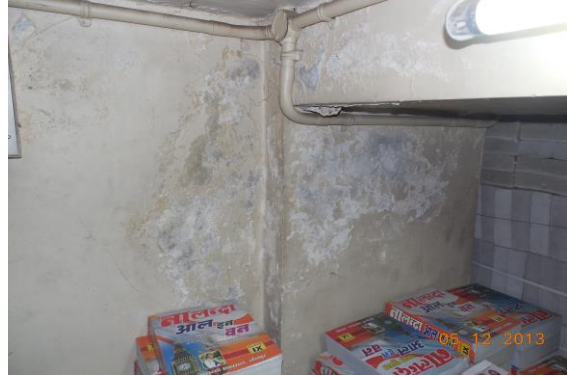
Photo 87

Dampness/Seepage on Wall No. 1 of Shop no.148 of Upper ground floor

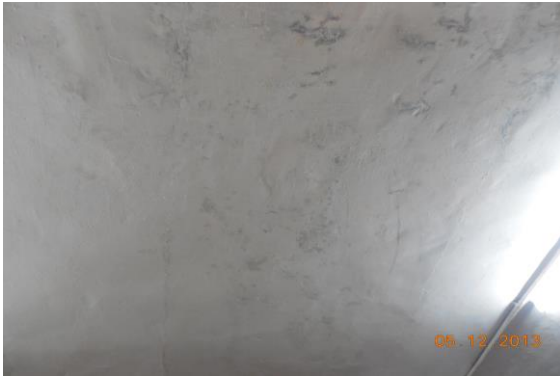
Photo 88

Dampness/Seepage on Roof of Varanda of Shop of Ground Floor

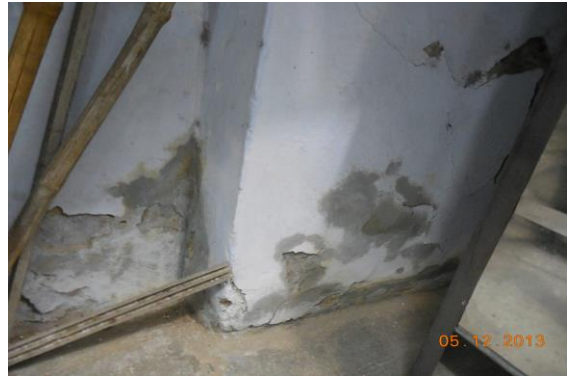
Photo 89

Dampness/Seepage on Wall No. 1 of Shop no.149 of Ground Floor

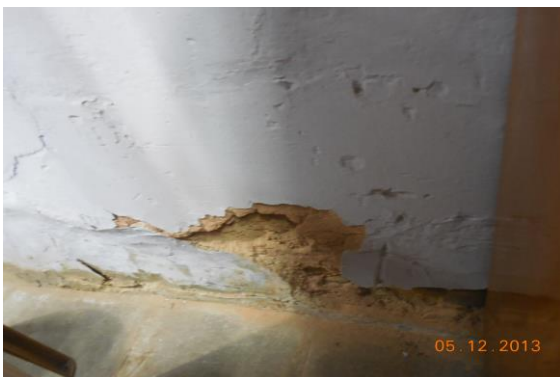
Photo 90

Peeling of Plaster on Wall No. 2 of Shop no.149 of Ground Floor

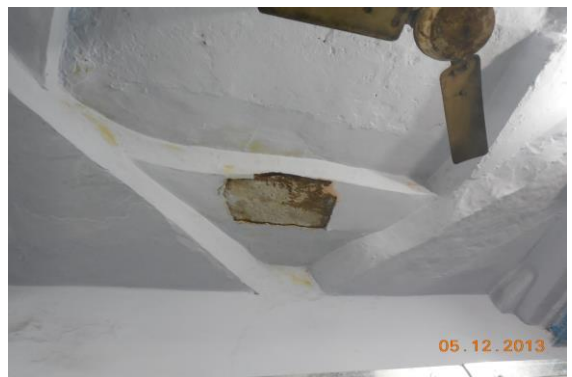
Photo 91

Peeling of Plaster on Roof of Shop no.149 of Ground Floor

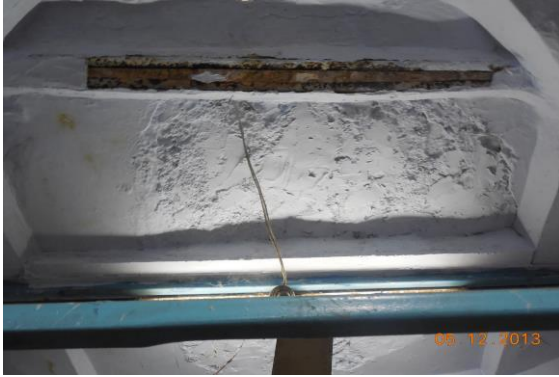
Photo 92

Peeling of Plaster on Roof & Backside of Shop no.149 of Ground Floor

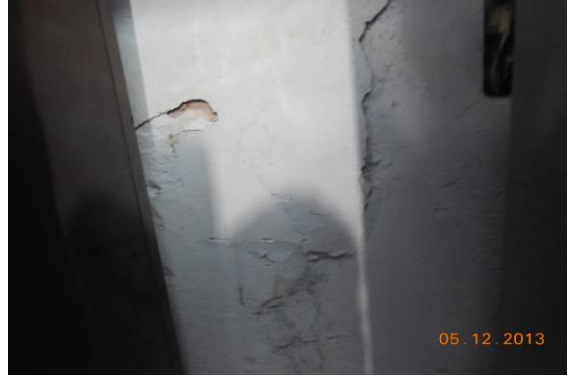
Photo 93

Peeling of Plaster on Wall No. 4 of Shop no.149 of Ground Floor

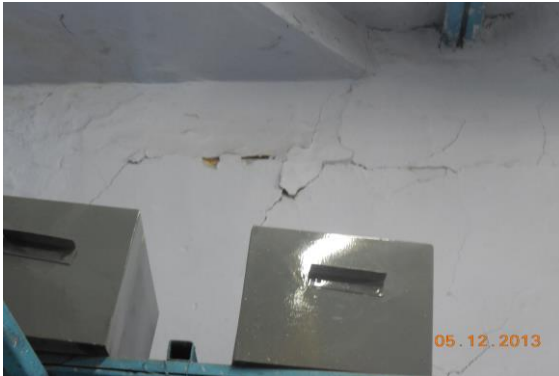
Photo 94

Peeling of Plaster on Wall No. 2 of Shop no.149 of Ground Floor

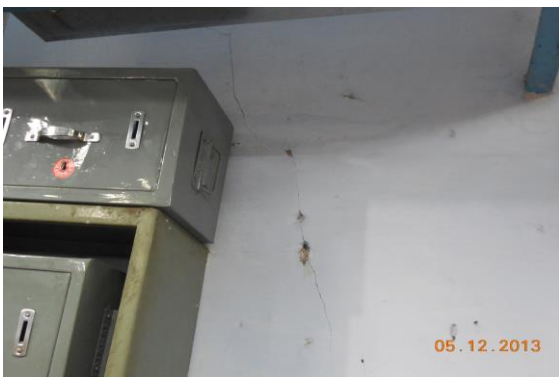
Photo 96

Peeling of Plaster on Wall No. 2 of Shop no.149 of Ground Floor

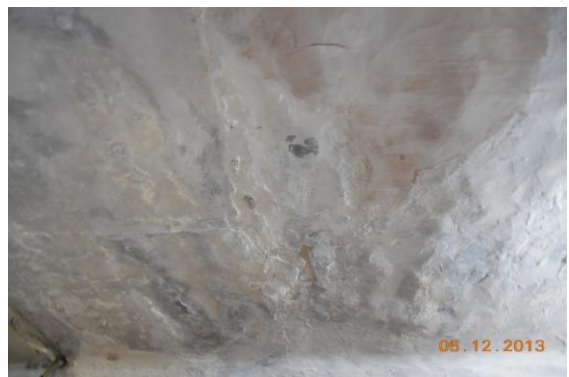
Photo 97

Dampness/Seepage on Roof of Varanda of Shop of

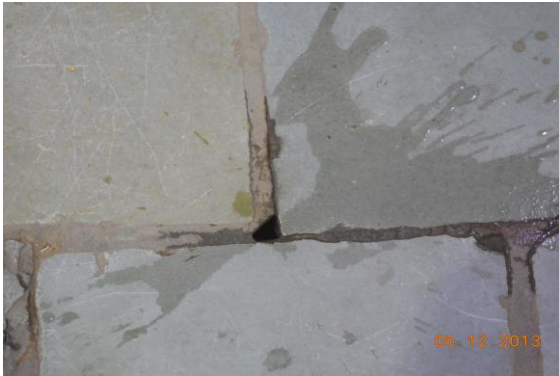
Photo 98

Peeling of Plaster on Floor of Shop no.150 of Ground Floor

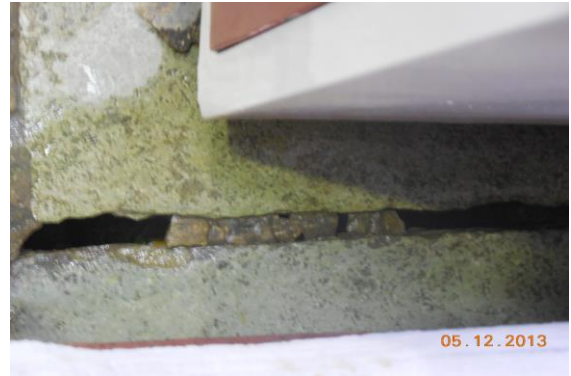
Photo 99

Peeling of Plaster on Floor of Shop no.150 of Ground Floor

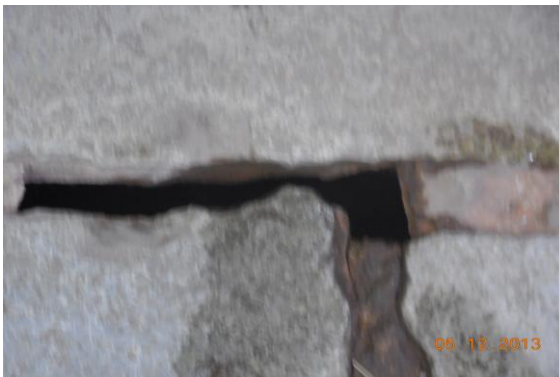
Photo 100

Peeling of Plaster on Floor of Shop no.150 of Ground Floor

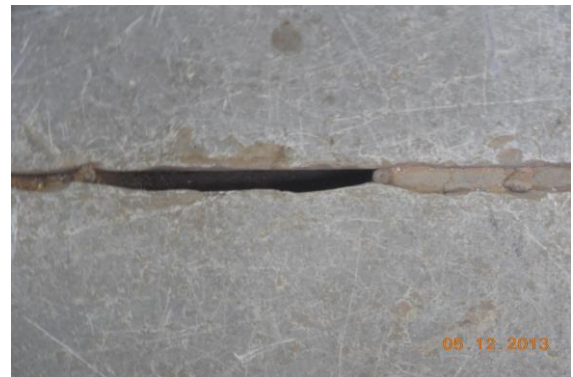
Photo 101

Peeling of Plaster on Floor of Shop no.150 of Ground Floor

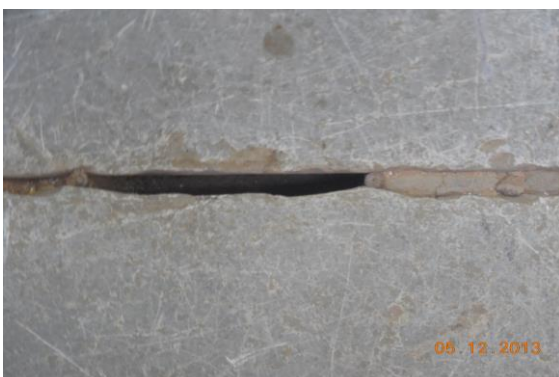
Photo 102

Peeling of Plaster on Floor of Shop no.150 of Ground Floor

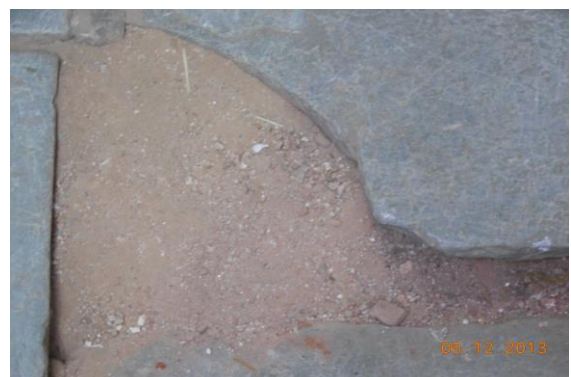
Photo 103

Peeling of Plaster on Floor of Shop no.150 of Ground Floor

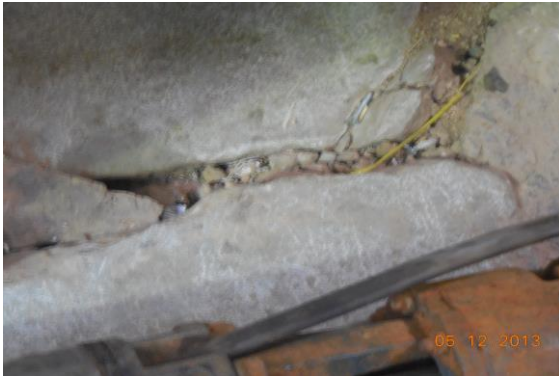
Photo 104

Peeling of Plaster on Floor of Shop no.150 of Ground Floor

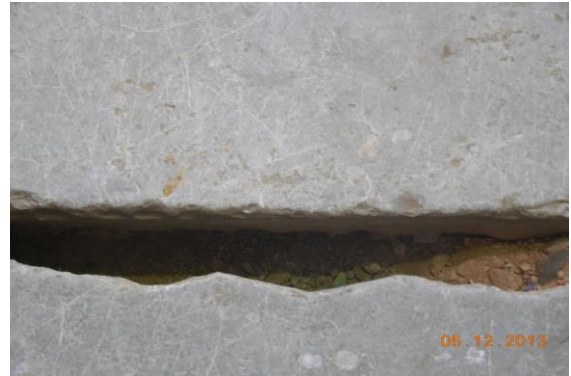
Photo 105

Peeling of Plaster on Floor of Shop no.150 of Ground Floor

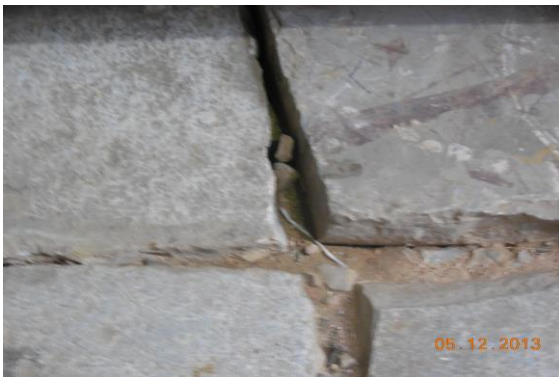
Photo 106

Peeling of Plaster on Floor of Shop no.150 of Ground Floor

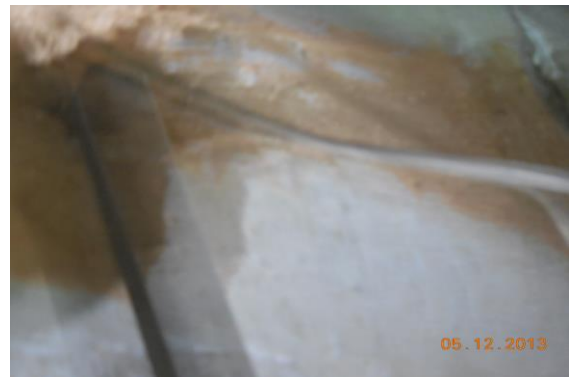
Photo 107

Peeling of Plaster on Wall No. 1 of Shop no.150 of Ground Floor

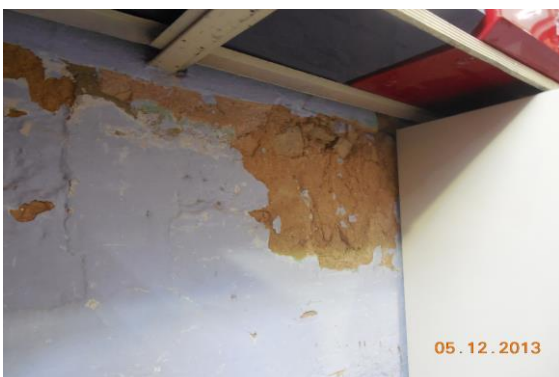
Photo 108

Peeling of Plaster on Wall No. 1 of Shop no.150 of Ground Floor

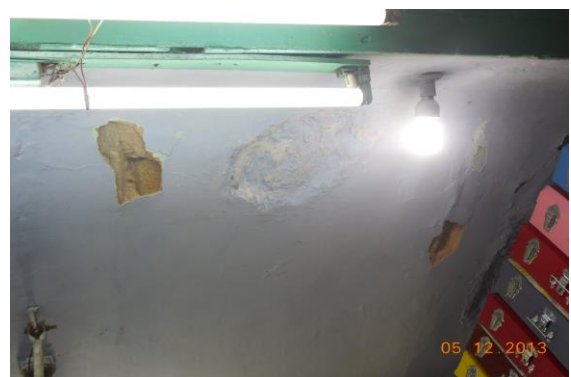
Photo 109

Peeling of Plaster on Roof of Shop no.150 of Ground Floor

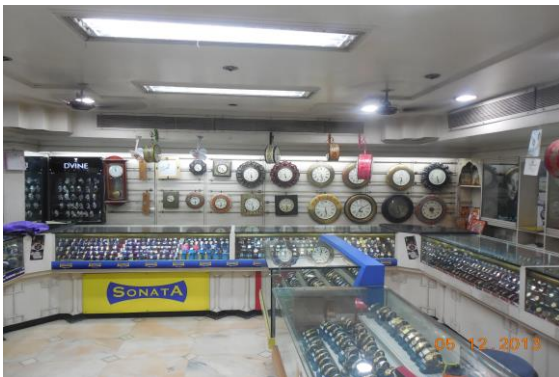
Photo 135

Wall No. 1, 2 & 4 of Shop No.142 & 143 of Ground Floor Covered with wooden

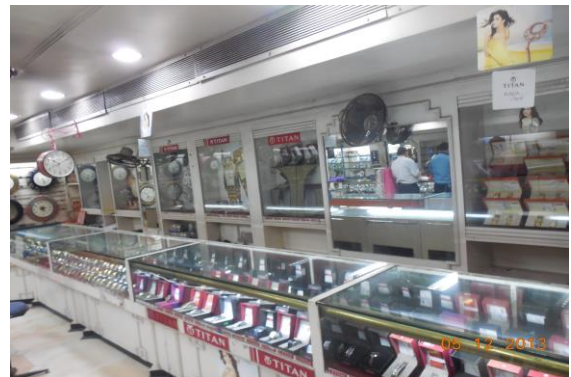
Photo 136

Wall No. 1, 2 & 4 of Shop No.142 & 143 of Ground Floor Covered with wooden

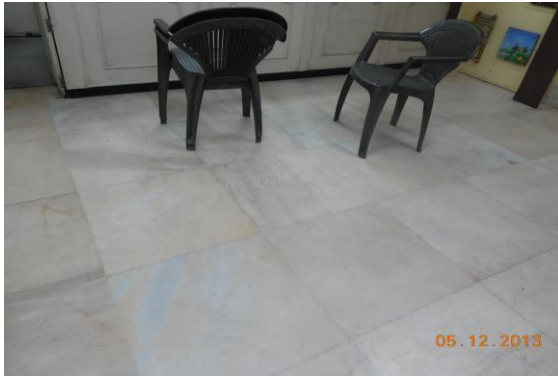
Photo 139

Floor of Shop No.142 & 143 of Ground Floor Covered with tiles

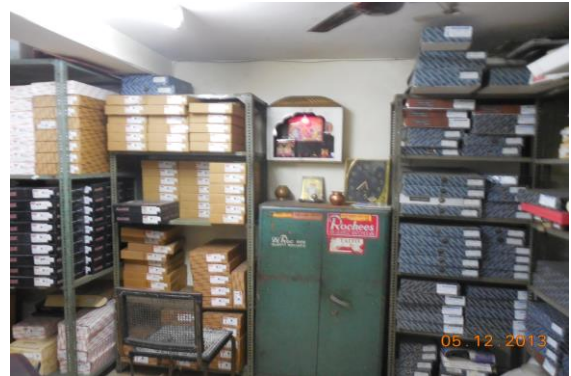
Photo 140
Floor of Shop No.142 & 143 of Basement Covered with tiles

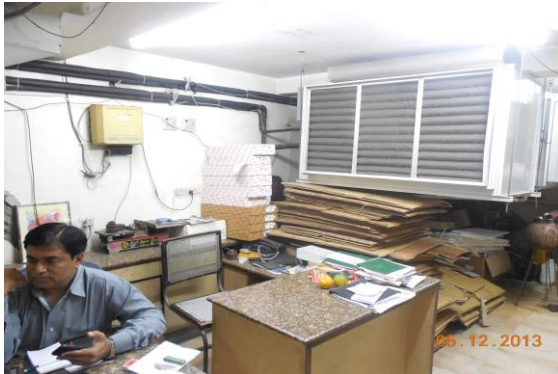
Photo 141
Wall No. 4 of Shop No.142 & 143 of Basement No.2 Covered with Material

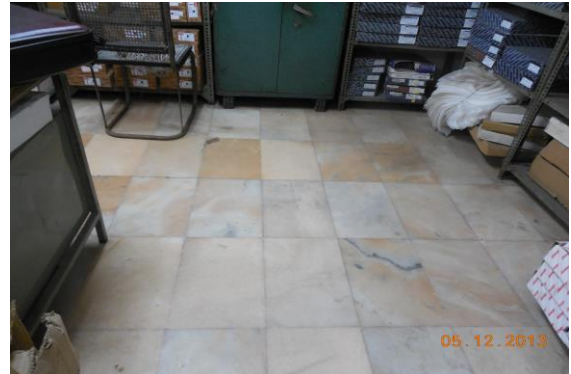
Photo 142
Wall No. 3 of Shop No.142 & 143 of Basement No.2 Covered with Material

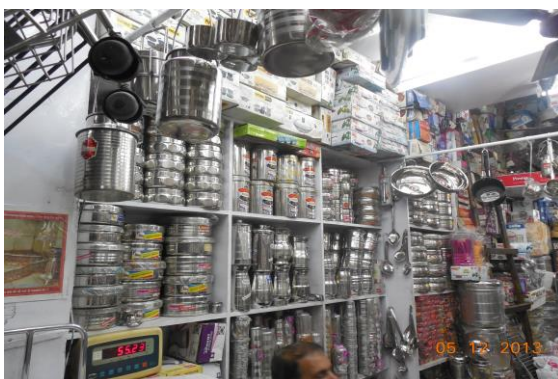
Photo 143
Floor of Shop No.142 & 143 of Basement No.2 Covered with tiles

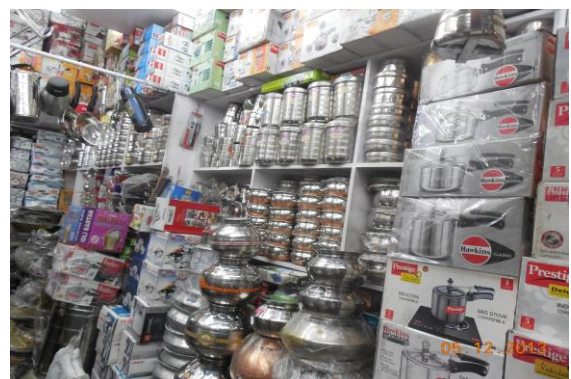
Photo 144
Wall No. 1 of Part A of Shop of Ground Floor Covered with Material

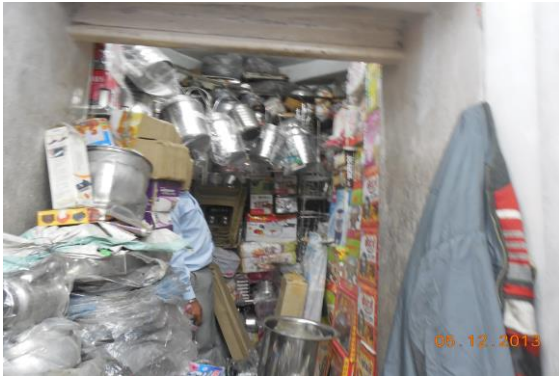
Photo 145
Wall No. 2 of Part A of Shop of Ground Floor Covered with Material

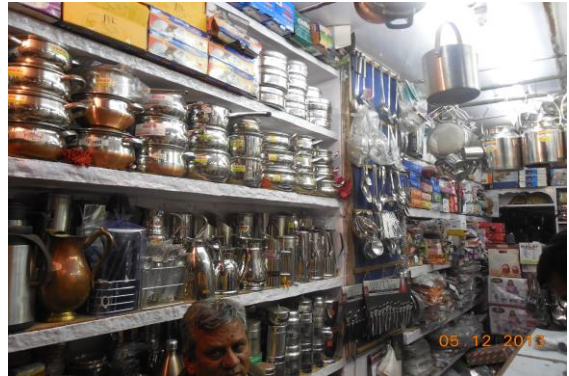
Photo 146

All Walls of Part B of Shop of Ground Floor Covered with Material

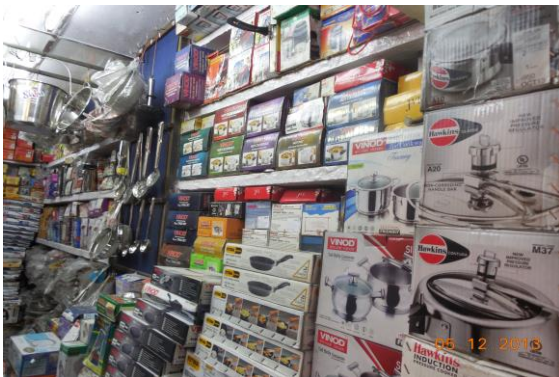
Photo 147

Wall No. 1 of Part A of Shop of Ground Floor Covered with Material & wooden Partition

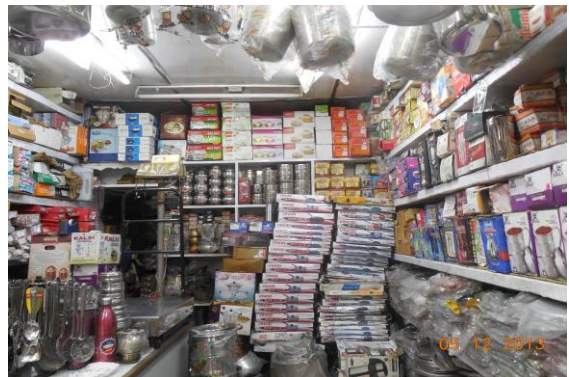
Photo 148

Wall No. 2 of Part A of Shop of Ground Floor Covered with Material & wooden Partition

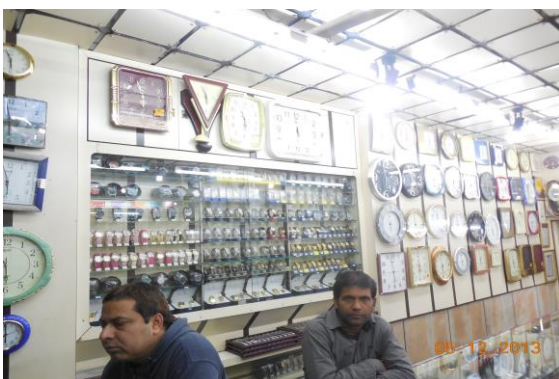
Photo 149

Wall No. 4 of Part A of Shop of Ground Floor Covered with Material & wooden Partition

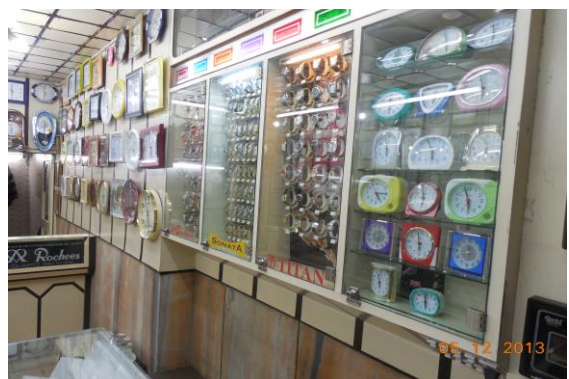
Photo 150

Wall No. 1 of Shop No.146 of Ground Floor Covered With Wooden & Watch

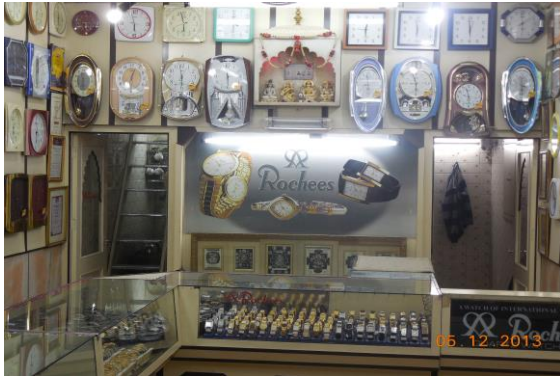
Photo 151

Wall No. 2 of Shop No.146 of Ground Floor Covered With Wooden & Watch

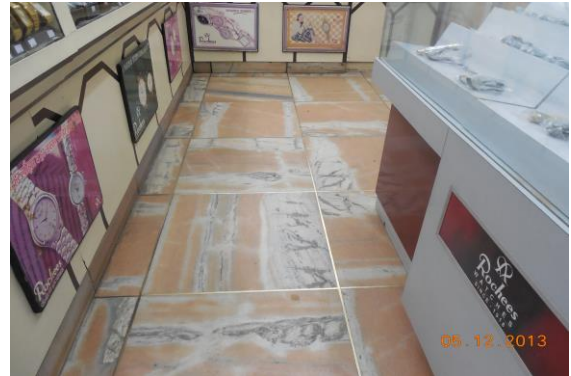
Photo 152

Wall No. 4 of Shop No.146 of Ground Floor Covered With Wooden & Watch

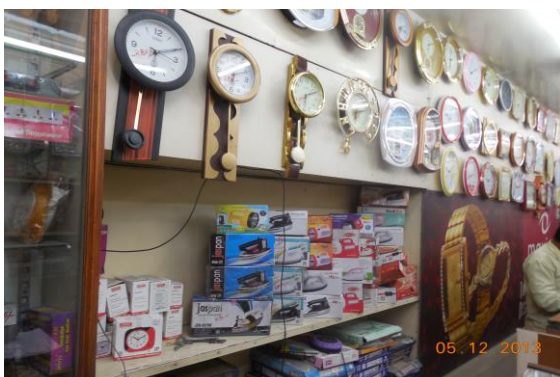
Photo 155

All Walls of Shop No.146 of Ground Floor Half Covered With Marbels & Tiles

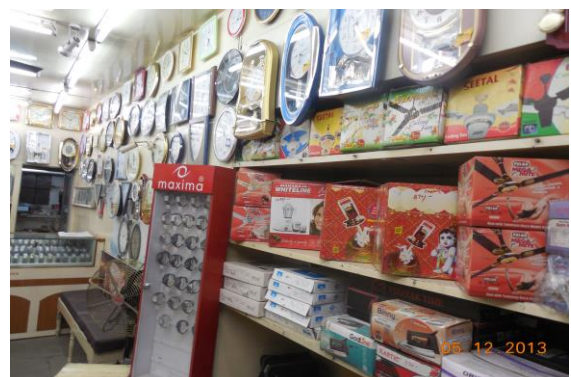
Photo 156

Wall No. 1 of Shop no.147 of Ground Floor Covered With Wooden & Watch

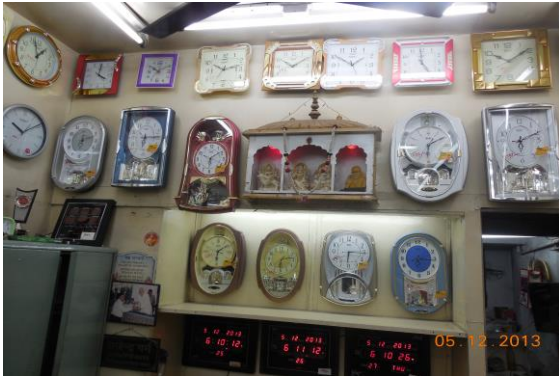
Photo 157

Wall No. 2 of Shop no.147 of Ground Floor Covered With Wooden & Watch

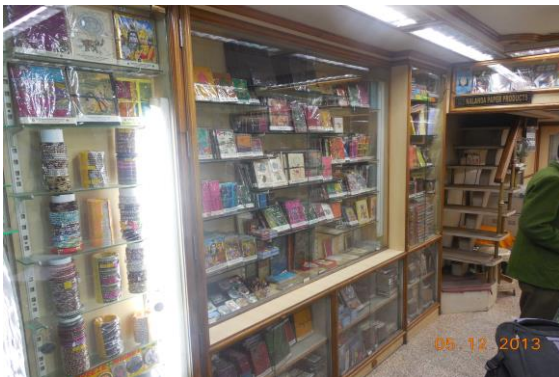
Photo 159

Roof of Shop no.147 of Ground Floor Covered with falls Ceiling

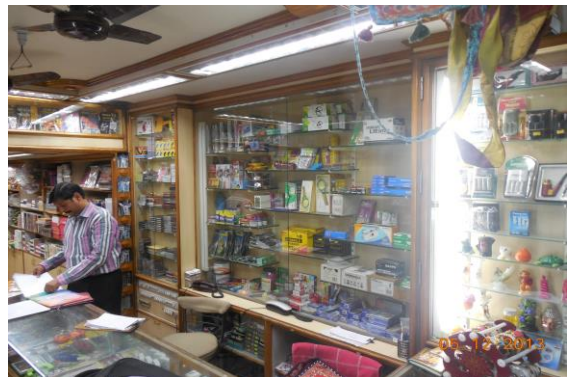
Photo 160

Wall No. 1 of Shop no.148 of Ground Floor Covered With Wooden Rack & Material

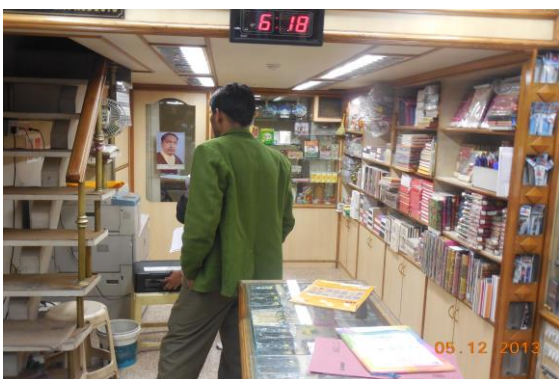
Photo 161

Wall No. 2 of Shop no.148 of Ground Floor Covered With Wooden Rack & Material

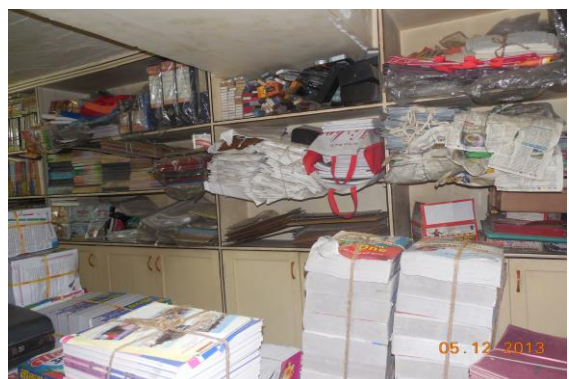
Photo 162

Wall No. 4 of Shop no.148 of Ground Floor Covered With Wooden Rack & Material

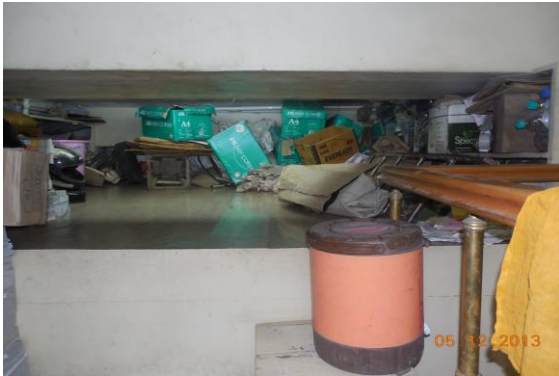
Photo 163

Wall No. 2 of Shop no.148 of Upper ground floor Covered with Material

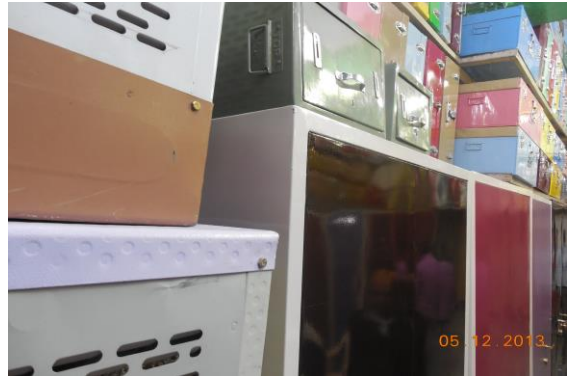
Photo 164

Wall No. 3 of Shop no.148 of Upper ground floor Covered with Material

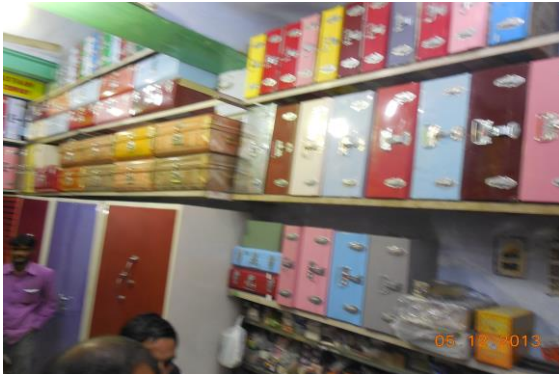
Photo 165

Wall No. 1 of Shop no.150 of Ground Floor Covered With material

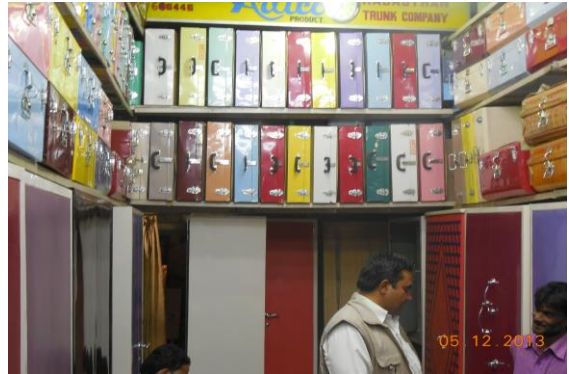
Photo 166

Wall No. 2 of Shop no.150 of Ground Floor Covered With material

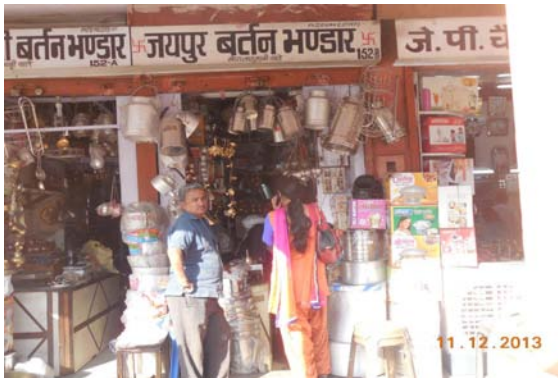
Photo 1
View of Shop No.152 B Jaipur Batan Bhandar

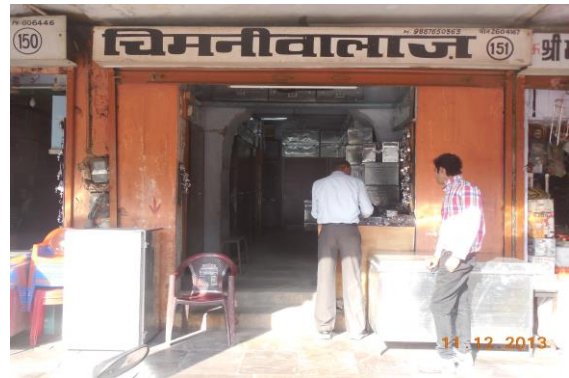
Photo 2
View of Shop No.151 Chimni Walaz, Ground Floor

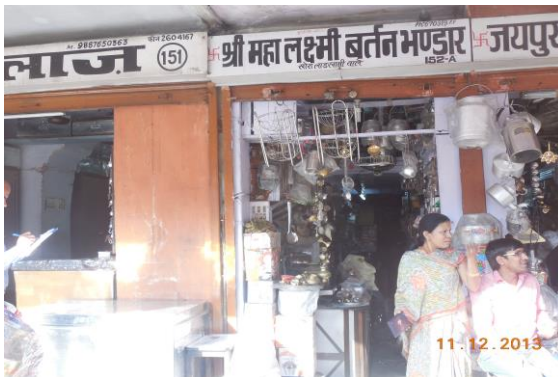
Photo 3
View of Shop No.152 A, Ground Floor

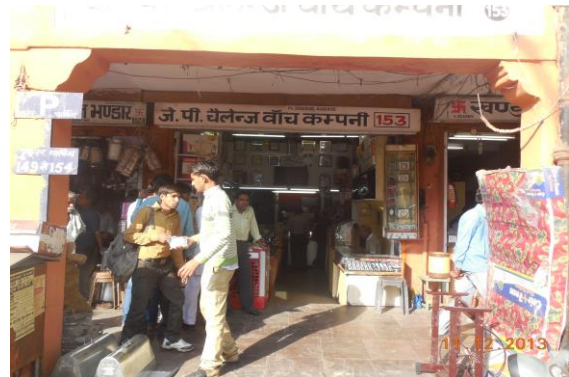
Photo 4
View of Shop No.153, Ground Floor

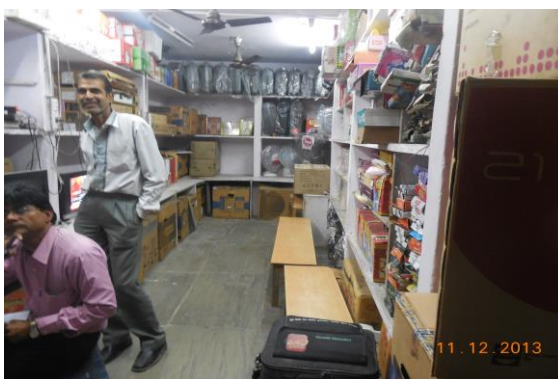
Photo 5
View of Basement, Basement

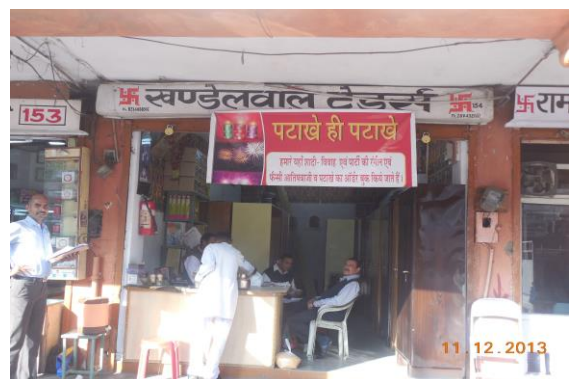
Photo 6
View of Shop No.154 Khandelwasl Treade, Ground Floor

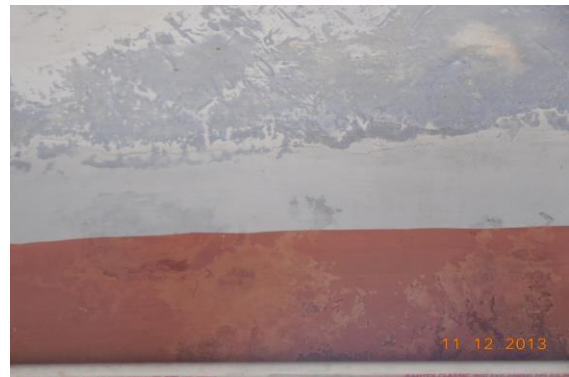
Photo 22
Horizontal Crack on Roof of Varanda of Shop No.151, Approx. Width = 0.15mm, Approx. Length = 2m. Distance from Left External Column = 1.5m, Height from Floor = 3m.

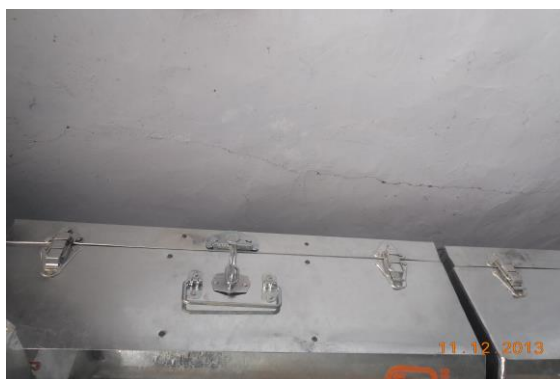
Photo 23
Horizontal Crack on Roof of Shop No.151, Ground Floor
Approx. Width = 0.4mm, Approx. Length = 2.15m.
Distance from Wall No.1 = 0.35m, Height from Floor = 2.5m.

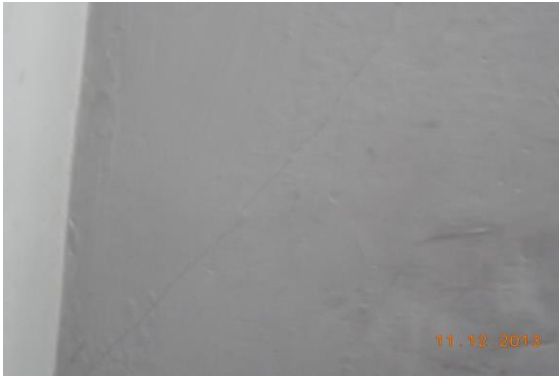
Photo 25

Inclined Crack on Wall No. 1 of Shop No.153, Ground Floor Approx. Width = 0.15mm, Approx. Length = 1.1m. Distance from Wall No.4 = 0.4m, Height from Floor = 0.5m.

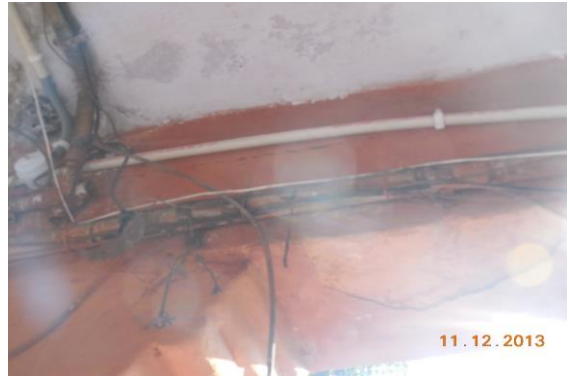
Photo 26

Horizontal Crack on External Beam of Varanda of Shop No.153, G/F Approx. Width = 1mm, Approx. Length = 1m. Distance from R/s External Column = Backsidem, Height from Floor = 2.6m.

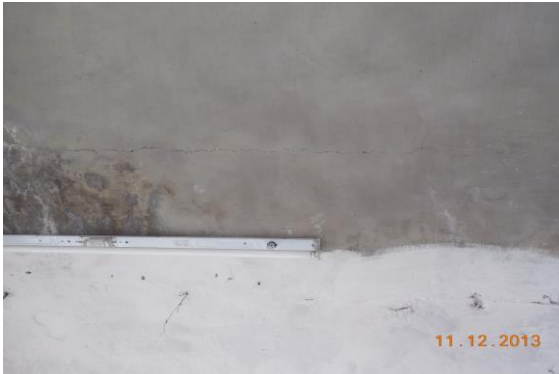
Photo 27

Horizontal Crack on Roof of Shop No.156, Ground Floor Approx. Width = 0.35mm, Approx. Length = 3m. Distance from Left External Column = Backsidem, Height from Floor = 3m

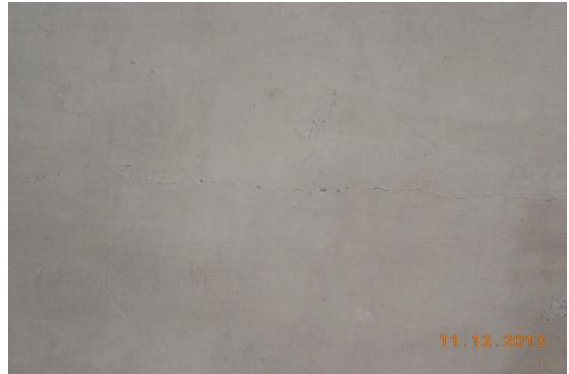
Photo 28

Horizontal Crack on Roof of Shop No.156, Ground Floor Approx. Width = 0.25mm, Approx. Length = 3m. Distance from Left External Column = 1.1m, Height from Floor = 3m.
