Pre Building Condition Survey Report

Name and Address of Structure :	Choti Chopar to Badi Chopar (UP Line)
---------------------------------	---------------------------------------

Name of the Project	Contract JMRC-UG1B “Design and Construction of Tunnel between Chandpole and Badi Chouper and reverse line by Shield TBM, Underground Metro Stations at Choti Chouper and Badi Chouper by Cut and Cover Methods on East West Corridor of Jaipur Metro Rail Corporation Limited .”	
Owner :

Shoping Complex - Shop No. 169-188
Tripolia Bazar
Jaipur
Unique ID: CC BC UP 0001

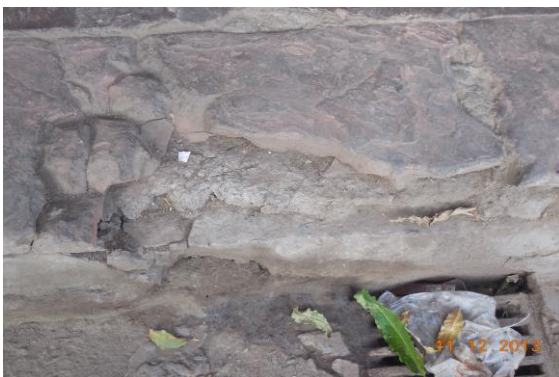
Photo 29

Horizontal Crack on Roof of Varanda of Shop No.159, Ground Floor Approx. Width = 0.4mm, Approx. Length = 2m. Distance from Left External Column = Backsidem, Height from Floor = 3m.

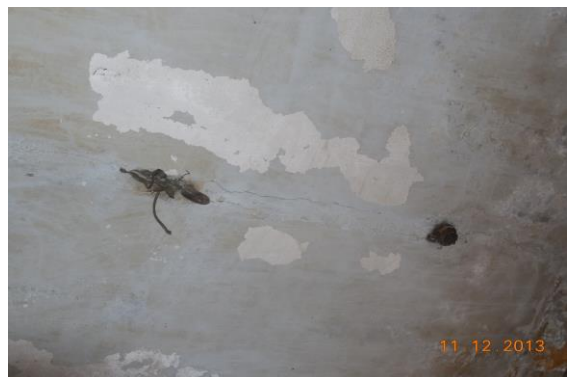
Photo 30

Horizontal Crack on Roof of Varanda of Shop No.163, Ground Floor Approx. Width = 0.3mm, Approx. Length = 3m. Distance from Left External Column = 1.2m, Height from Floor = 3m.

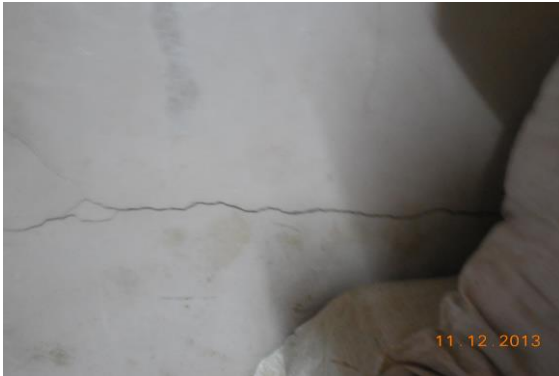
Photo 31

Horizontal Crack on Wall No. 4 of Shop No.164, Upper Ground Floor
Approx. Width = 1.5mm, Approx. Length = 1m. Distance from Wall No.1
= 0.4m, Height from Floor = 0.5m.

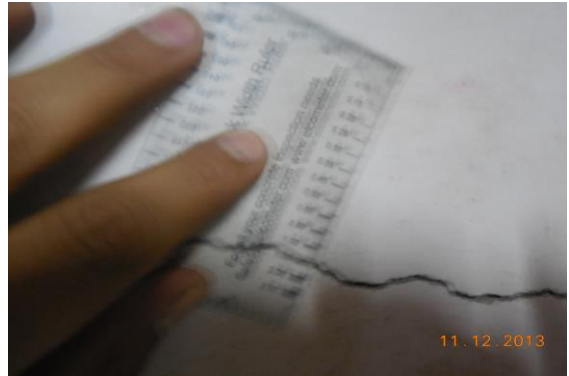
Photo 31A

Horizontal Crack on Wall No. 4 of Shop No.164, Upper Ground Floor
Approx. Width = 1.5mm, Approx. Length = 1m. Distance from Wall No.1
= 0.4m, Height from Floor = 0.5m.

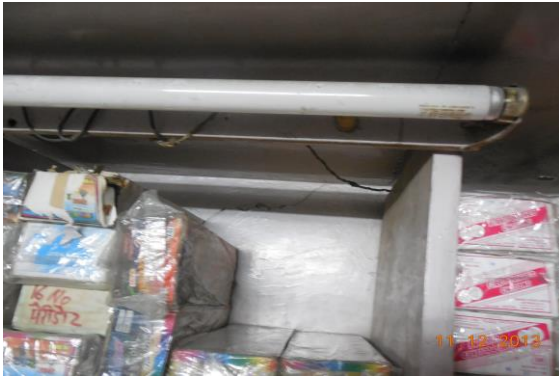
Photo 32

Inclined Crack on Wall No. 2 of Shop No.164, Upper Ground Floor
Approx. Width = 0.8mm, Approx. Length = 1.5m.
Distance from Wall No.3 = 4m, Height from Floor = 1.6m.

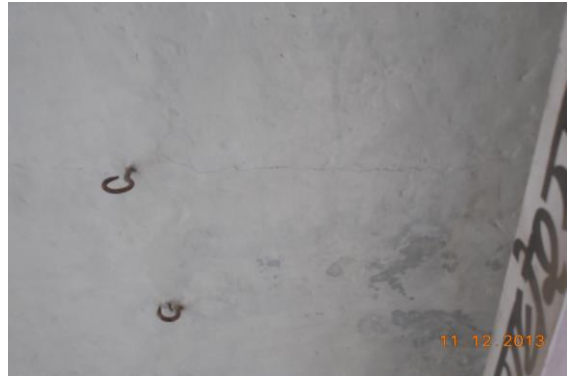
Photo 33

Horizontal Crack on Roof of Varanda of Shop No.164, Ground Floor
Approx. Width = 0.4mm, Approx. Length = 2m. Distance from Left
External Column = 1.2m, Height from Floor = 3m.

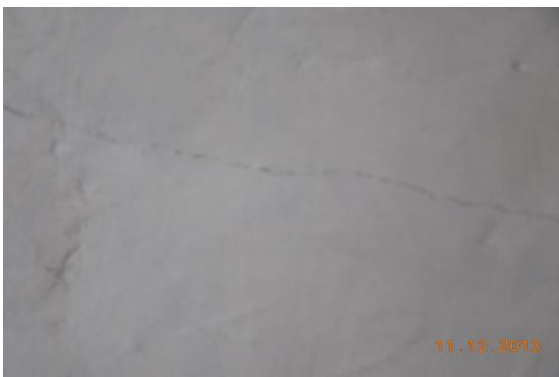
Photo 34

Horizontal Crack on Roof of Varanda of Shop No.164, Ground Floor
Approx. Width = 0.35mm, Approx. Length = 2m. Distance from Left
External Column = 2m, Height from Floor = 3m.

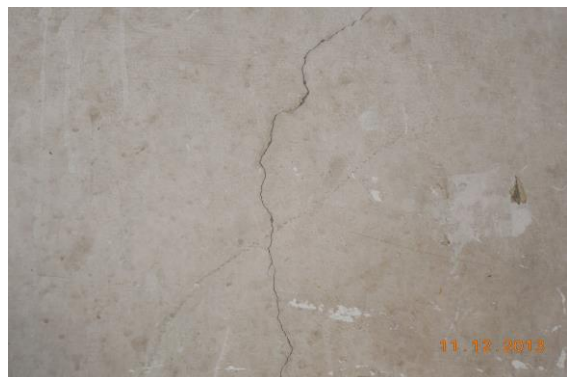
Photo 35

Inclined Crack on Wall No. 3 of Shop No.166, Upper Ground Floor
Approx. Width = 0.8mm, Approx. Length = 1.3m. Distance from Wall
No.1 = 1.5m, Height from Floor = 0m.

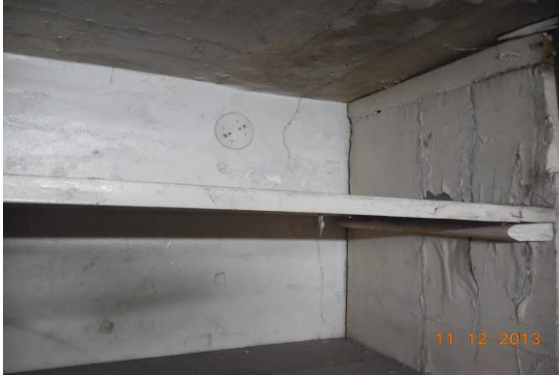
Photo 36

Inclined Crack on Wall No. 1 of Shop No.165, Upper Ground Floor
Approx. Width = 0.4mm, Approx. Length = 1.5m.
Distance from Wall No.3 = 2.5m, Height from Floor = 0.6m.

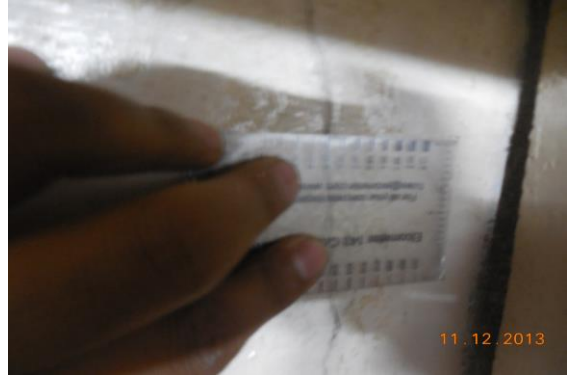
Photo 36A

Inclined Crack on Wall No. 1 of Shop No.165, Upper Ground Floor
Approx. Width = 0.4mm, Approx. Length = 1.5m.
Distance from Wall No.3 = 2.5m, Height from Floor = 0.6m.

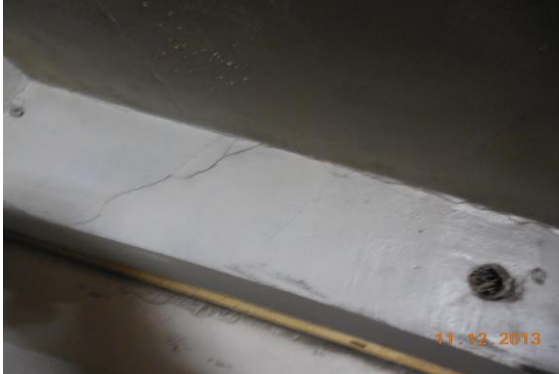
Photo 37

Inclined Crack on Wall No. 4 of Shop No.165, Upper Ground Floor
Approx. Width = 0.8mm, Approx. Length = 0.5m.
Distance from Wall No.1 = 0.3m, Height from Floor = 1.5m.

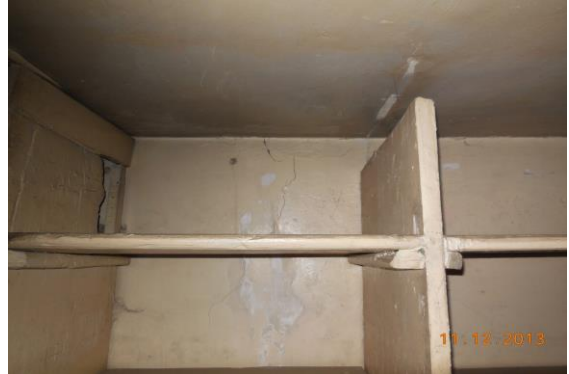
Photo 38

Inclined Crack on Wall No. 2 of Shop No.165, Upper Ground Floor
Approx. Width = 0.4mm, Approx. Length = 1.2m.
Distance from Wall No.4 = 1m, Height from Floor = 1.5m.

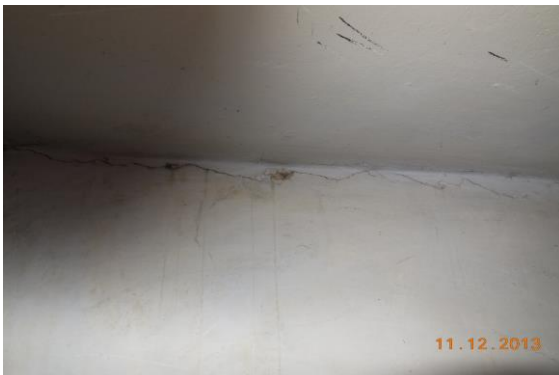
Photo 39

Horizontal Crack on Wall No. 4 of Staircase area, Upper Ground Floor
Approx. Width = 1mm, Approx. Length = 1m. Distance from Wall No.2 = 0m, Height from Floor = 1.8m.

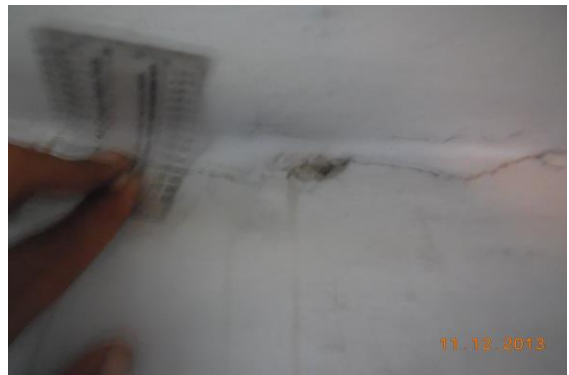
Photo 39A

Horizontal Crack on Wall No. 4 of Staircase area, Upper Ground Floor
Approx. Width = 1mm, Approx. Length = 1m. Distance from Wall No.2 = 0m, Height from Floor = 1.8m.

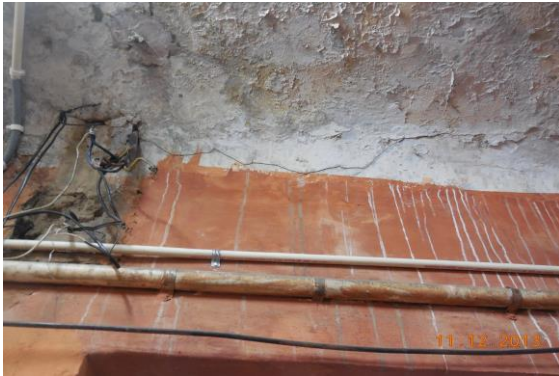
Photo 40

Inclined Crack on Roof of Varanda of Shop No.165, Ground Floor
Approx. Width = 1mm, Approx. Length = 1m. Distance from Rightside
External Column = Backsidem, Height from Floor = 3m.

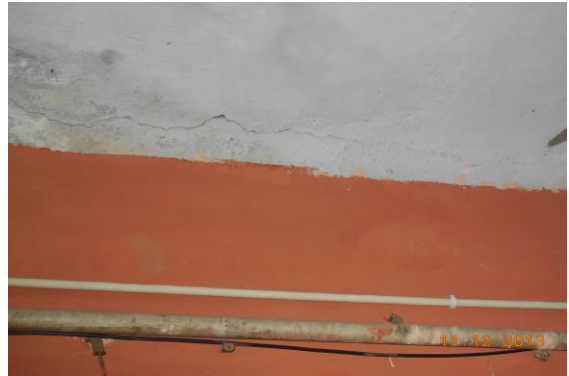
Photo 41

Inclined Crack on Roof of Varanda of Shop No.167, Ground Floor
Approx. Width = 1mm, Approx. Length = 3.2m. Distance from Rightside
External Column = 0m, Height from Floor = 3m.

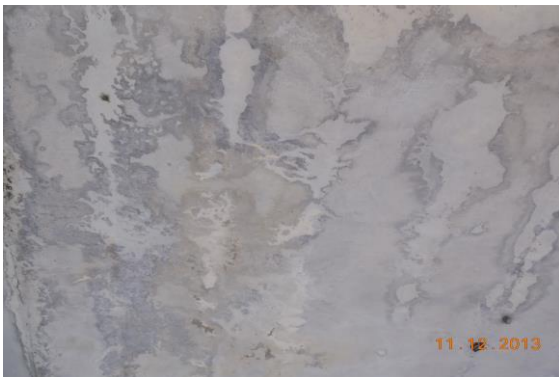
Photo 42

Dampness/Seepage on Roof of Varanda of Shop No.151 of Ground
Floor

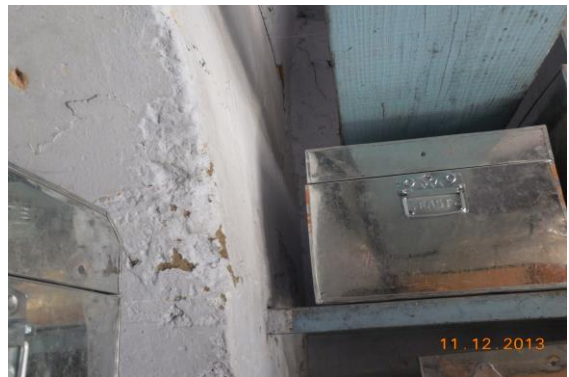
Photo 43

Peeling of Plaster on Wall No. 2 of Shop No.151 of Ground Floor

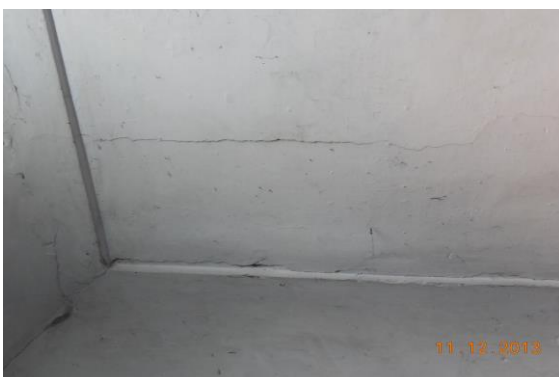
Photo 44

Plaster Crack on Roof of Shop No.151 of Ground Floor

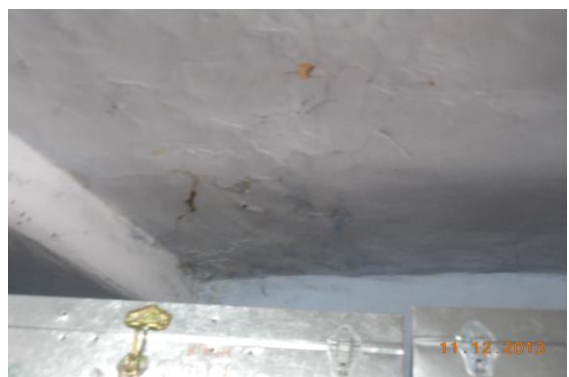
Photo 45

Dampness/Seepage on Roof of Shop No.151 of Ground Floor

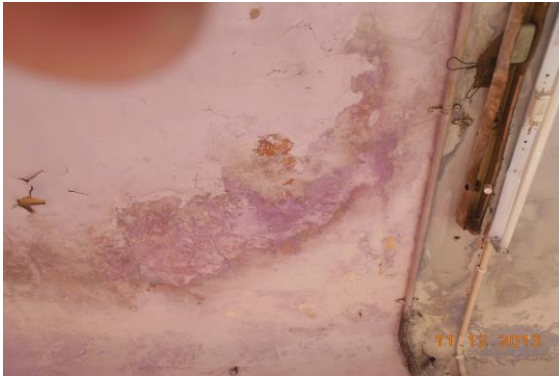
Photo 46

Dampness/Seepage on Roof of Varanda of Shop No.152 A of Ground Floor

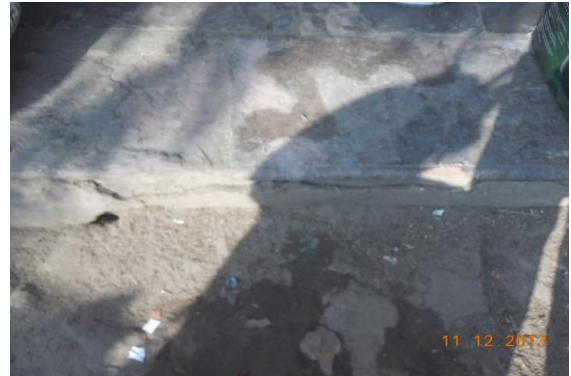
Photo 47

Damaged Portion on Floor of Varanda of Shop No.152 B of Ground Floor

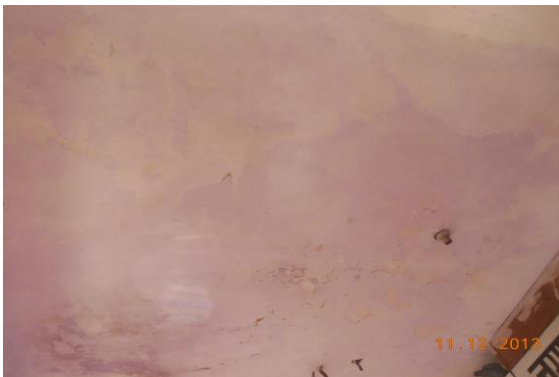
Photo 48

Dampness/Seepage on Roof of Varanda of Shop No.152 B of Ground Floor

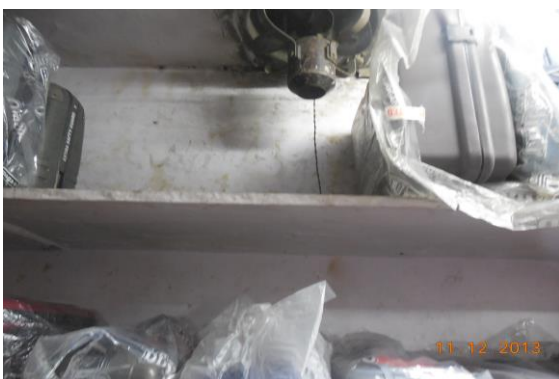
Photo 50

Dampness/Seepage on Wall No. 2 of Shop No.153 of Basement

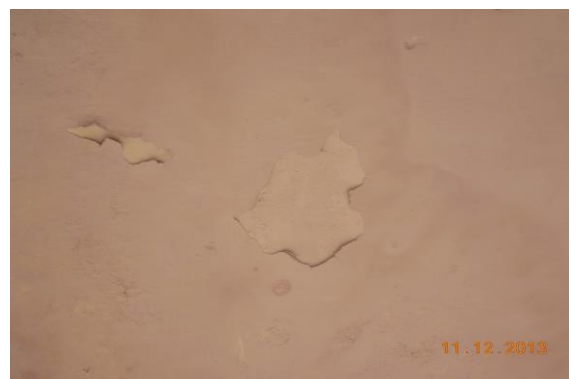
Photo 51

Peeling of Plaster on Roof of Shop No.153 of Ground Floor

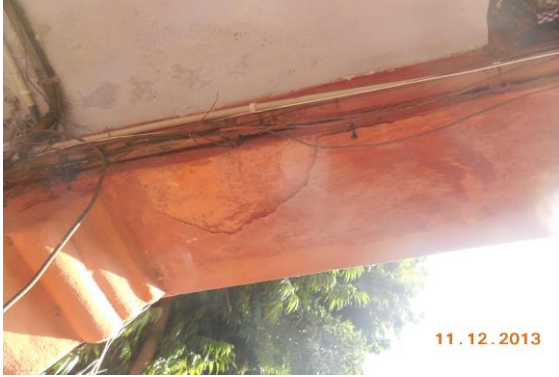
Photo 52

Peeling of Plaster on External Beam of Varanda of Shop No.153 of Ground Floor

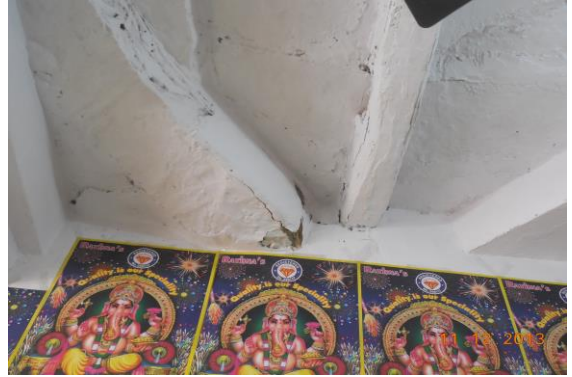
Photo 53

Peeling of Plaster on Roof of Shop No.154 of Ground Floor

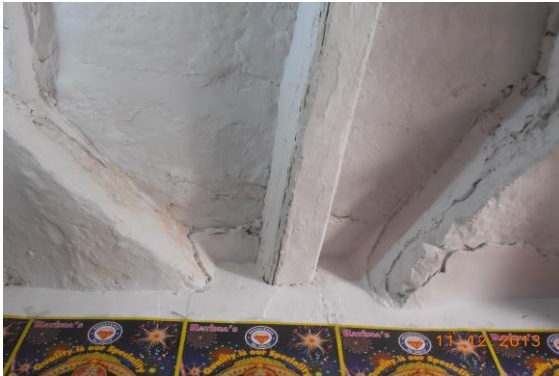
Photo 54

Peeling of Plaster on Roof of Shop No.154 of Ground Floor

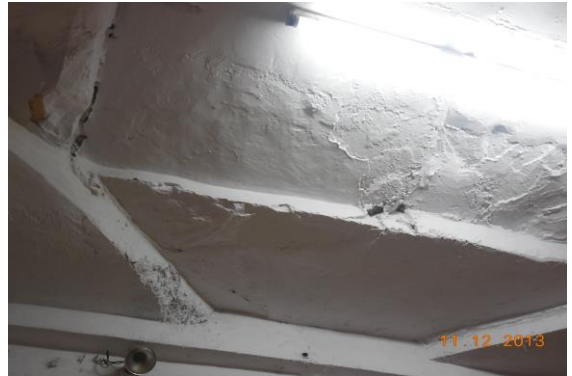
Photo 55

Peeling of Plaster on Roof of Shop No.154 of Ground Floor

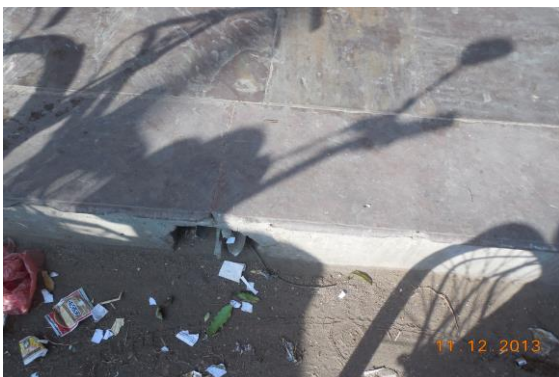
Photo 56

Peeling of Plaster on Floor of Varanda of Shop No.154 of Ground Floor

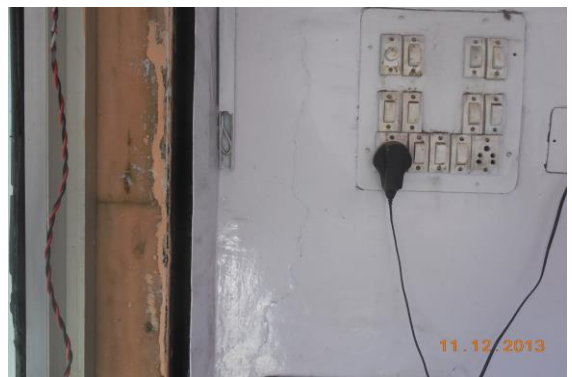
Photo 57

Plaster Crack on Wall No. 1 of Shop No.155 of Ground Floor

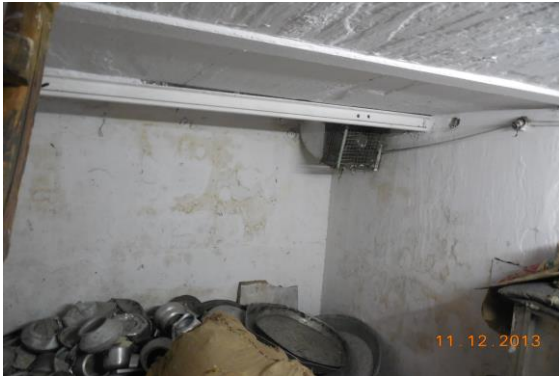
Photo 58

Dampness/Seepage on Wall No. 1 & 3 of Shop No.155 of Basement

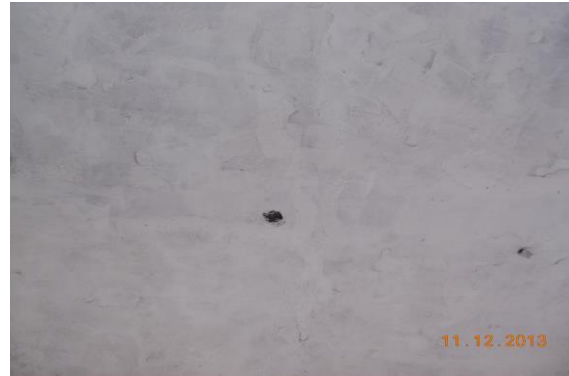
Photo 59

Dampness/Seepage on Roof of Varanda of Shop No.155 of Ground Floor

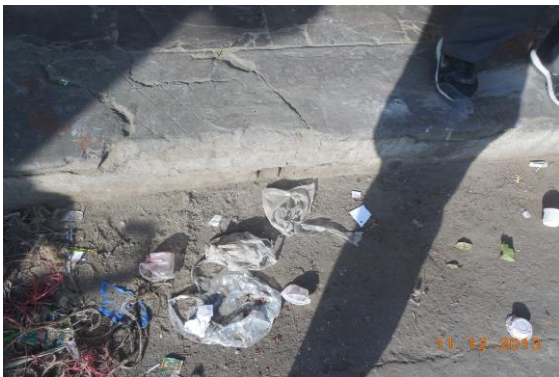
Photo 60

Damaged Portion on Floor of Varanda of Shop No.155 of Ground Floor

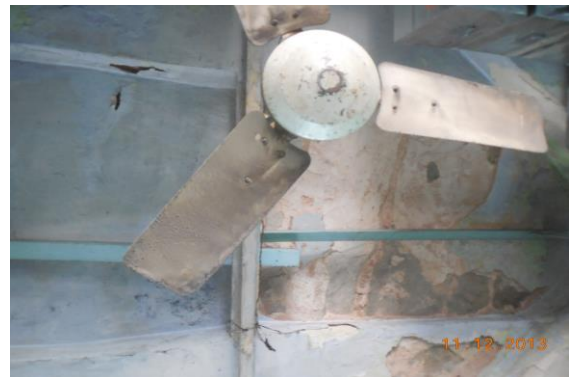
Photo 61

Peeling of Plaster on Roof of Shop No.156 of Ground Floor

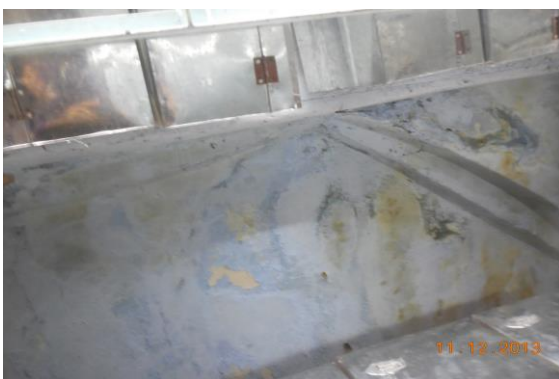
Photo 62

Dampness/Seepage on Roof of Shop No.156 of Ground Floor

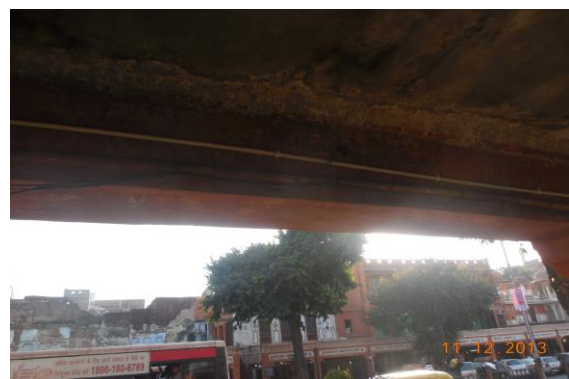
Photo 63

Dampness/Seepage on Roof of Shop No.156 of Ground Floor

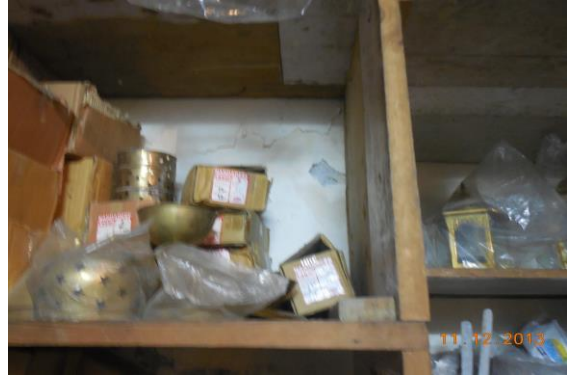
Photo 65
Peeling of Plaster on Wall No. 4 of Shop No.157 of Basement

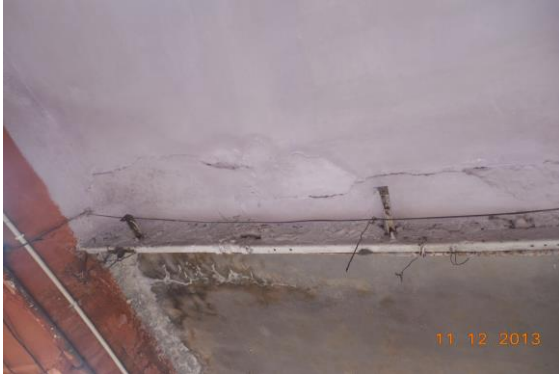
Photo 66
Damaged Portion on Roof of Varanda of Shop No.157 of Ground Floor

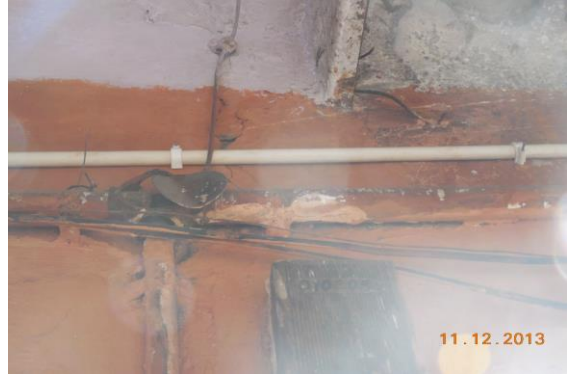
Photo 67
Damaged Portion on Leftside External Column Inside of Varanda of Shop No.157 of Ground Floor

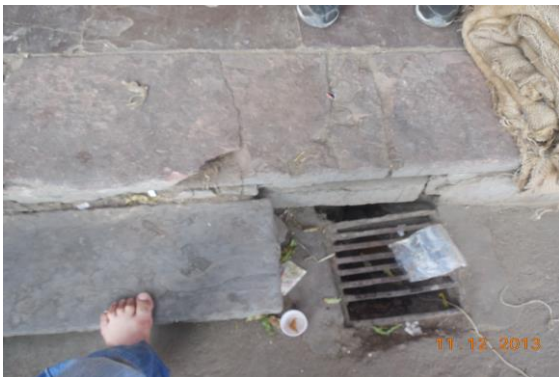
Photo 68
Damaged Portion on Floor of Varanda of Shop No.157 of Ground Floor

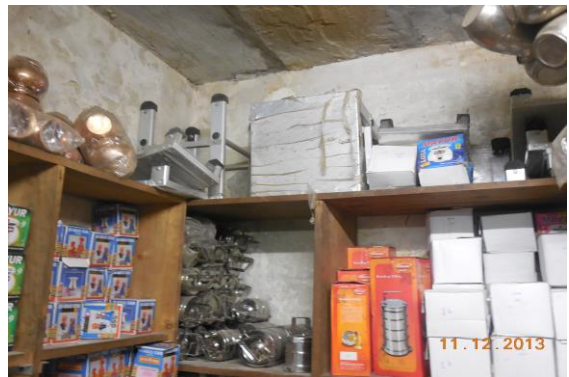
Photo 69
Dampness/Seepage on Wall No. 1 & 4 of Shop No.158 of Basement

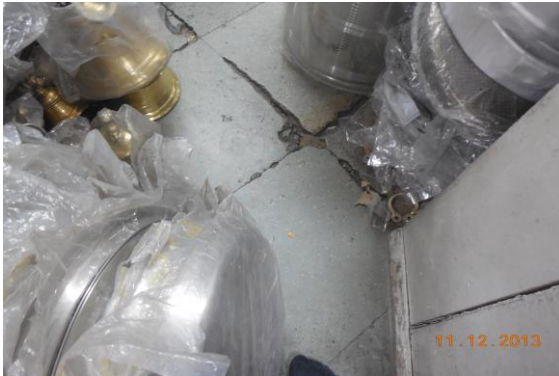
Photo 70

Damaged Portion on Floor of Shop No.159 of Ground Floor

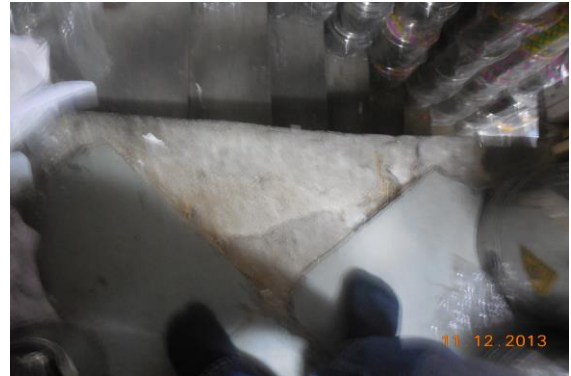
Photo 71

Damaged Portion on Floor of Shop No.159 of Ground Floor

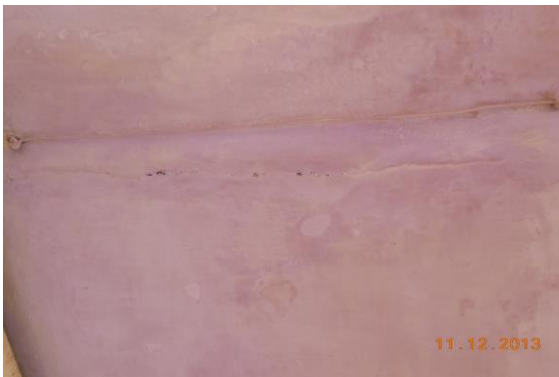
Photo 72

Peeling of Plaster on Floor of Varanda of Shop No.159 of Ground Floor

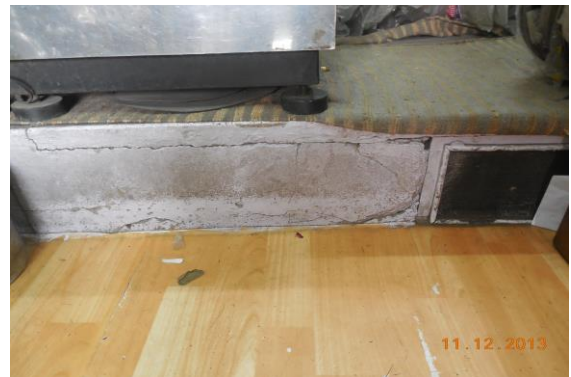
Photo 73

Plaster Crack on Floor of Shop No.160 of Ground Floor

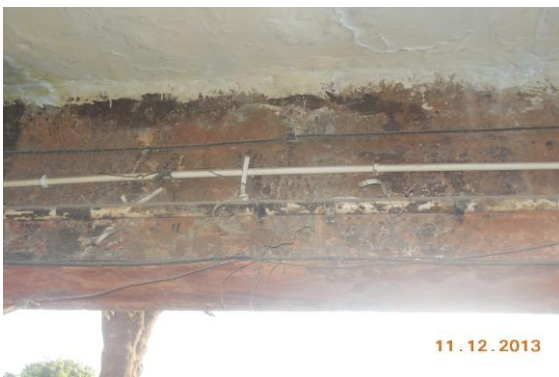
Photo 74

Dampness/Seepage on Roof of Varanda of Shop No.161 of Ground Floor

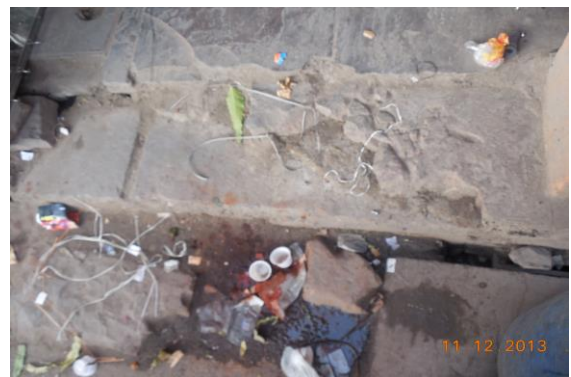
Photo 75

Peeling of Plaster on Floor of Varanda of Shop No.161 of Ground Floor

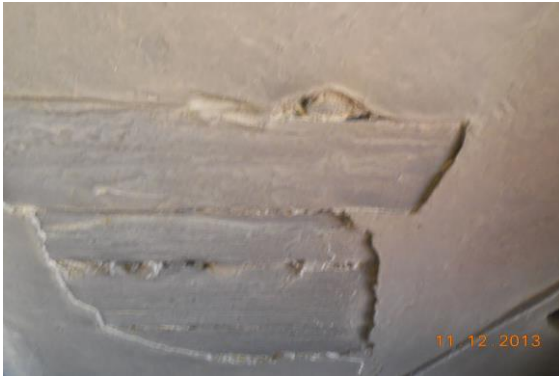
Photo 76

Peeling of Plaster on Roof of Part A of Shop No.162 of Ground Floor

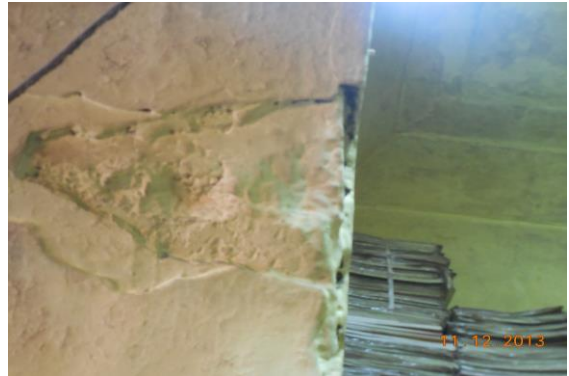
Photo 77

Peeling of Plaster on Entrance of Part B of Shop No.162 of Ground Floor

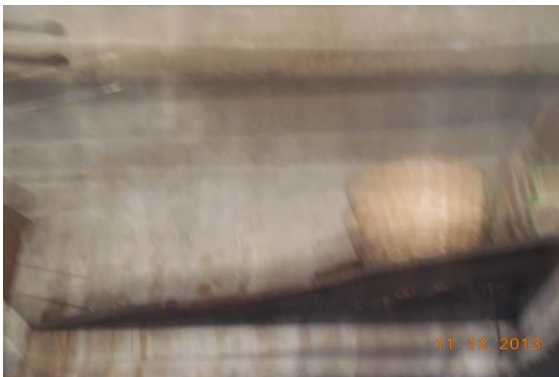
Photo 78

Dampness/Seepage on Wall No. 4 & Roof of Part C of Shop No.162 of Ground Floor

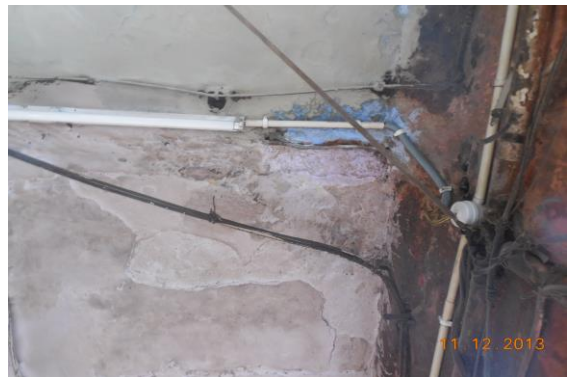
Photo 79

Peeling of Plaster on Roof of Varanda of Shop No.162 of Ground Floor

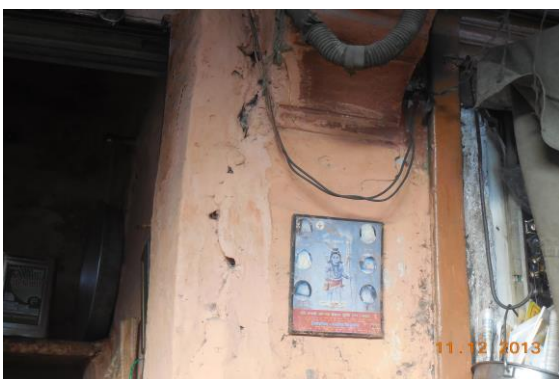
Photo 80

Peeling of Plaster on External Wall of Varanda of Shop No.162 A of Ground Floor

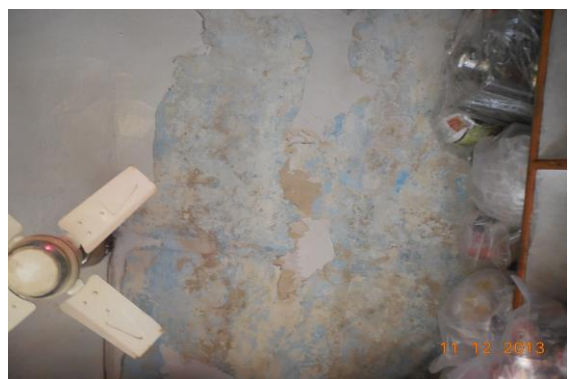
Photo 81

Dampness/Seepage on Roof of Part A of Shop No.163 of Ground Floor

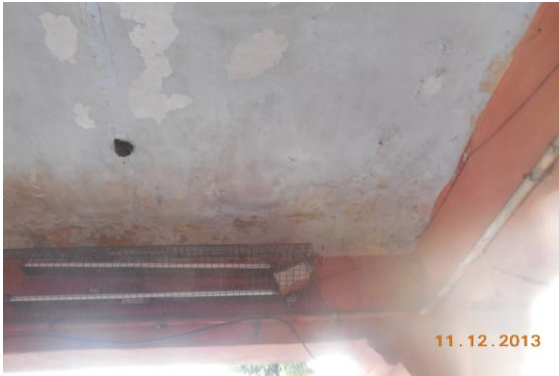
Photo 82

Dampness/Seepage on Roof of Varanda of Shop No.163 of Ground Floor

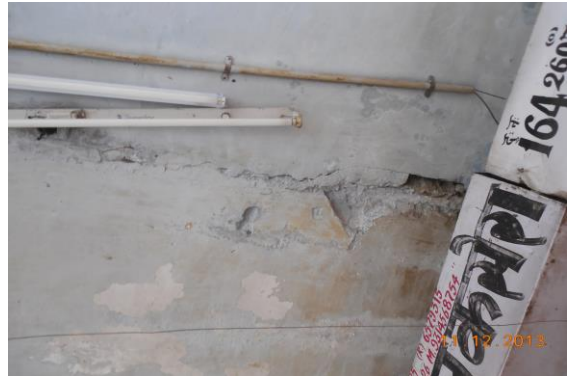
Photo 83

Damaged Portion on Roof of Varanda of Shop No.163 of Ground Floor

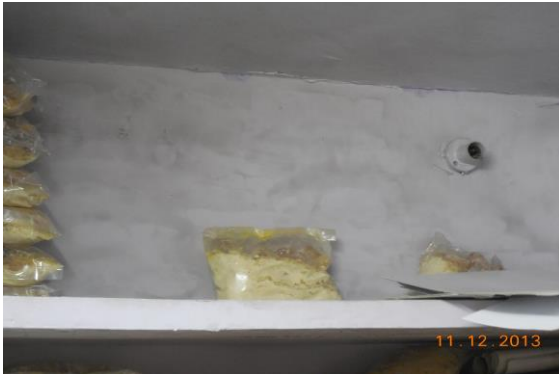
Photo 84

Dampness/Seepage on Wall No. 1 of Part B of Shop No.164 of Ground Floor

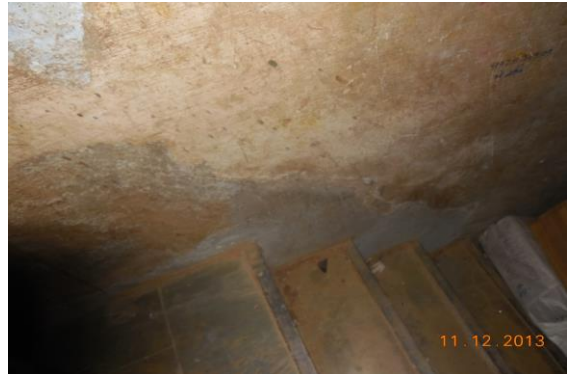
Photo 85

Peeling of Plaster on Staircase area Ground Floor To Basement of Ground Floor

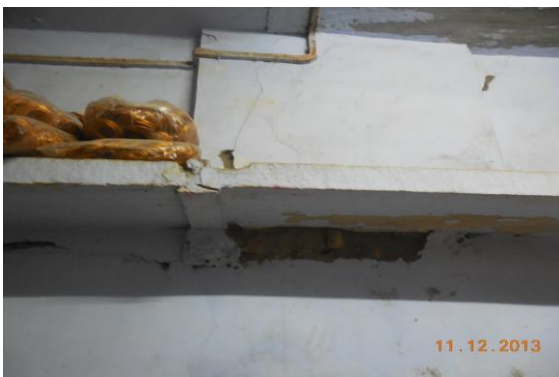
Photo 86

Peeling of Plaster on Wall No. 1 of Shop No.164 of Basement

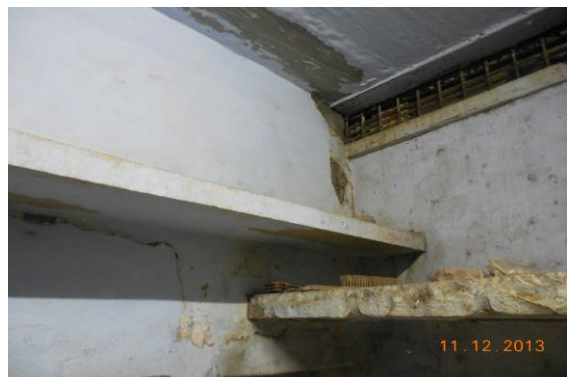
Photo 87

Peeling of Plaster on Wall No. 1 of Shop No.164 of Basement

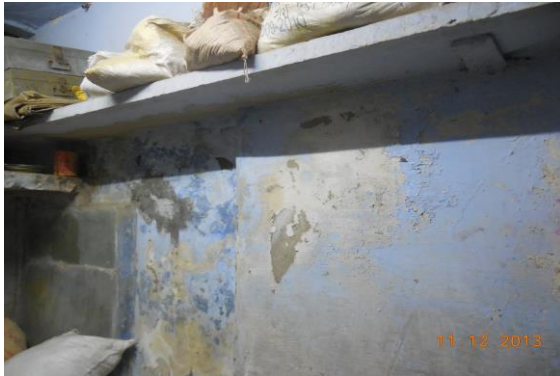
Photo 88

Dampness/Seepage on Wall No. 2 of Shop No.164 of Basement

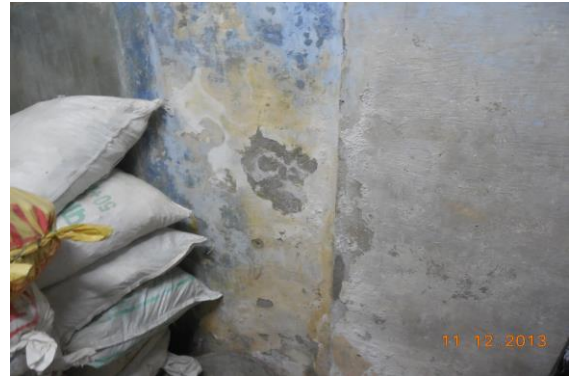
Photo 89

Dampness/Seepage on Wall No. 2 of Shop No.164 of Basement

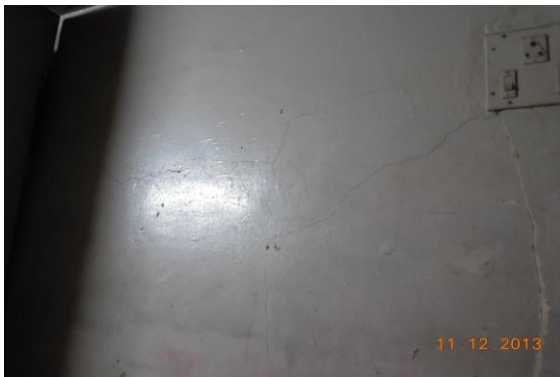
Photo 90

Plaster Crack on Wall No. 4 of Shop No.164 of Upper Ground Floor

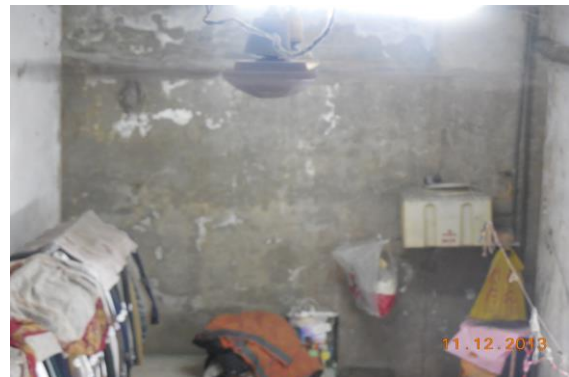
Photo 91

Dampness/Seepage on Wall No. 4 of Shop No.166 of Basement

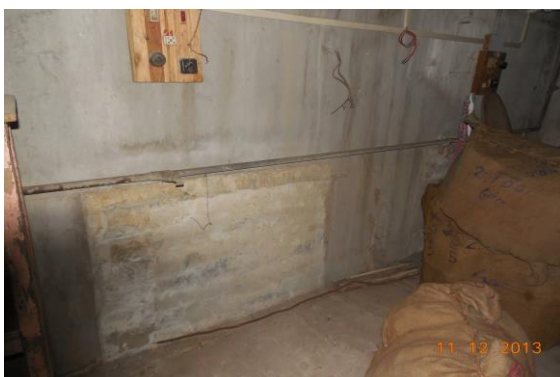
Photo 92

Dampness/Seepage on Wall No. 1 of Shop No.166 of Upper Ground Floor

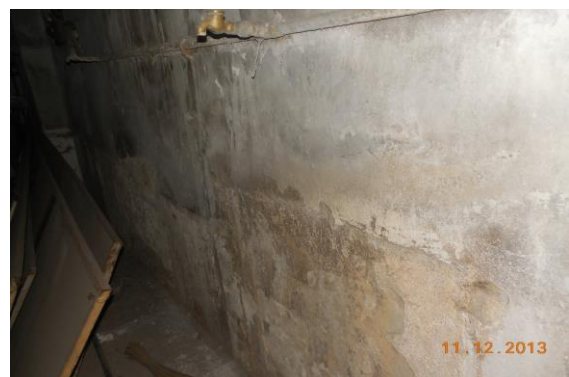
Photo 93

Dampness/Seepage on Wall No. 2 of Shop No.166 of Upper Ground Floor

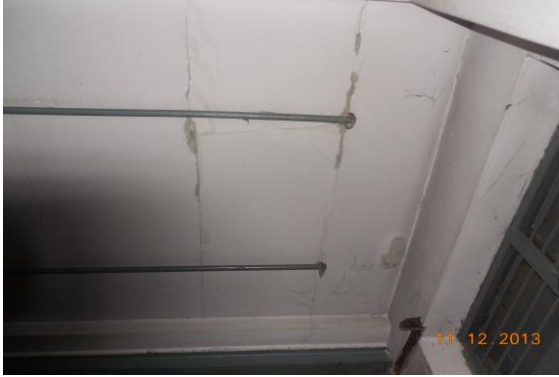
Photo 94

Peeling of Plaster on Roof of Shop No.166 of Upper Ground Floor

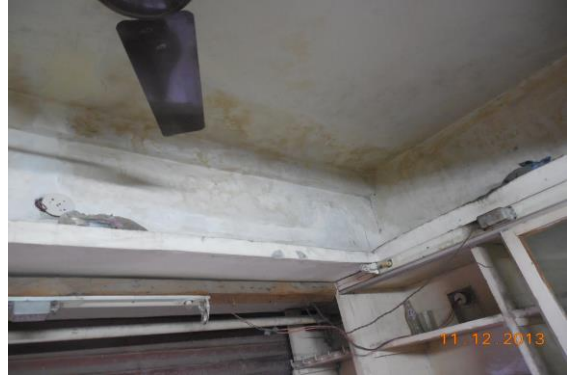
Photo 95

Dampness/Seepage on Wall No. 2, 3 & Roof of Part A of Shop No.166 of Ground Floor

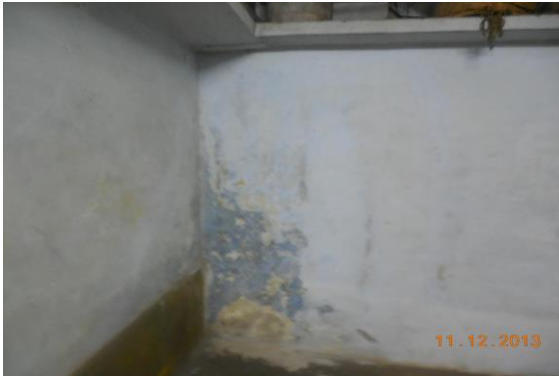
Photo 96

Dampness/Seepage on Wall No. 1 & 4 of Part A of Shop No.166 of Basement

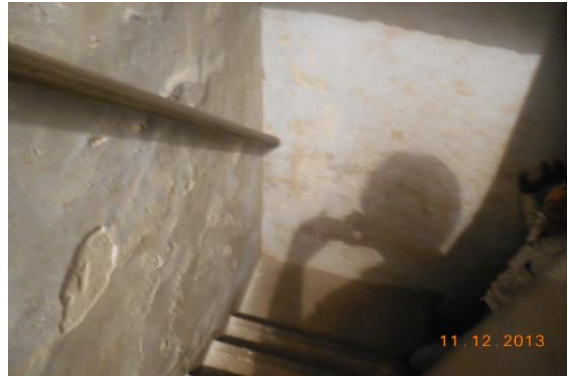
Photo 97

Dampness/Seepage on Wall No. 1 & 4 of Staircase Ground Floor To Basement of

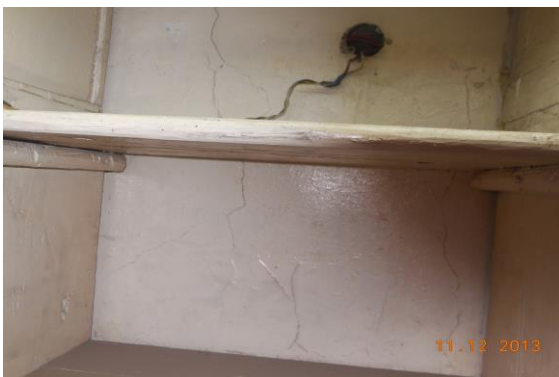
Photo 98

Plaster Crack on Wall No. 2 of Shop No.165 of Upper Ground Floor

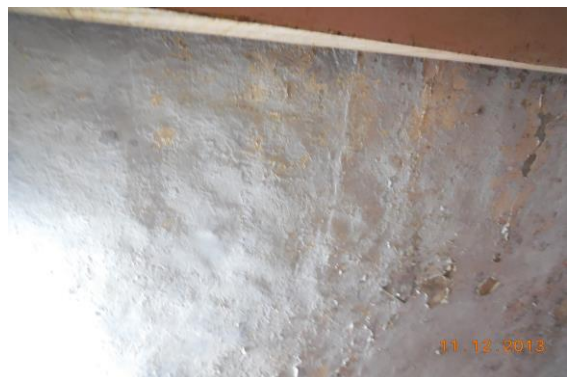
Photo 99

Dampness/Seepage on Roof of Varanda of Shop No.165 of Ground Floor

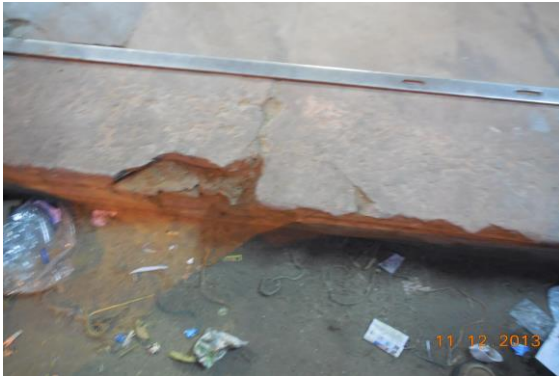
Photo 100
Damaged Portion on Floor & 3 of Varanda of Shop No.167 of Ground Floor

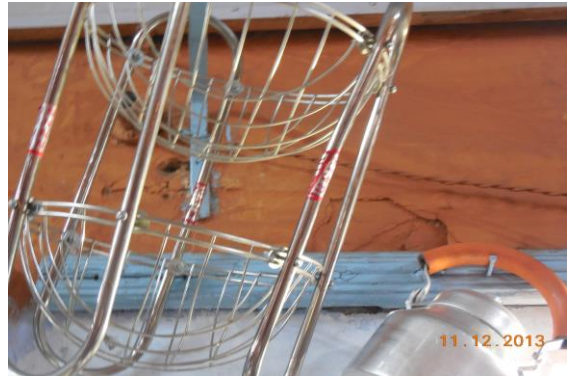
Photo 101
Peeling of Plaster on Outer Wall No.3 of Shop No.167 of Ground Floor

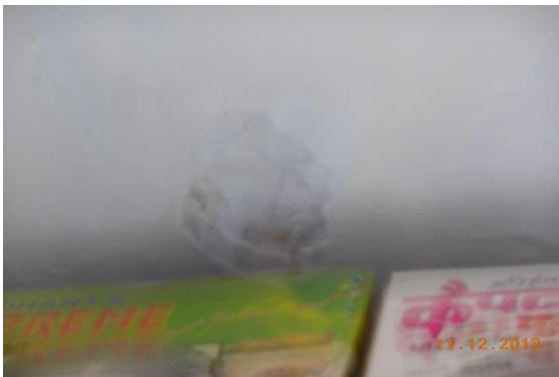
Photo 102
Peeling of Plaster on Roof of Part A of Shop No.167 of Ground Floor

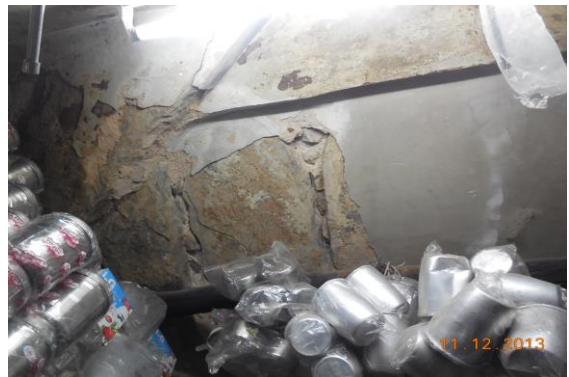
Photo 103
Peeling of Plaster on Roof of Part B of Shop No.167 of Ground Floor

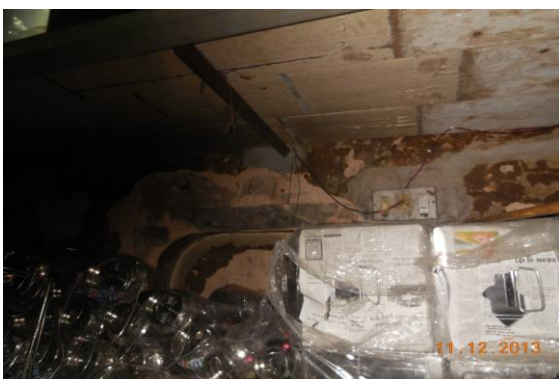
Photo 104
Peeling of Plaster on Wall No. 2 of Part B of Shop No.167 of Ground Floor

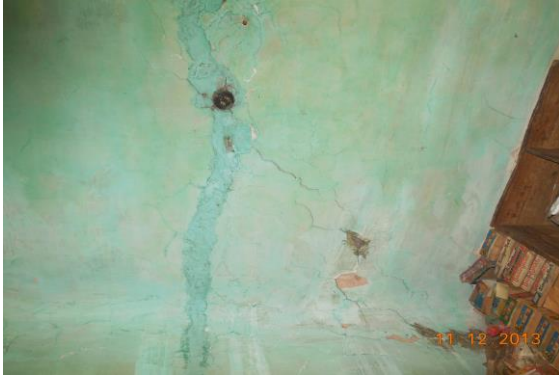
Photo 106

Damaged Portion on Roof of Part A of Shop No.168 of Ground Floor

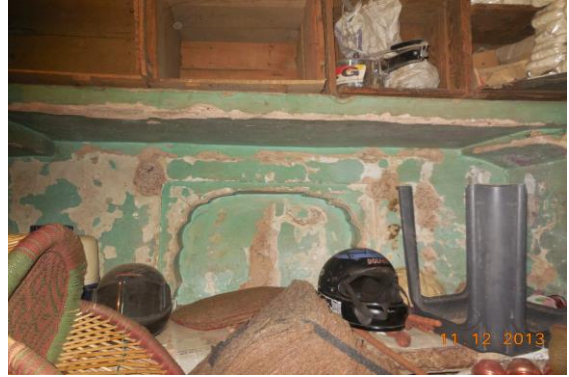
Photo 107

Damaged Portion on Wall No. 2 of Part A of Shop No.168 of Ground Floor

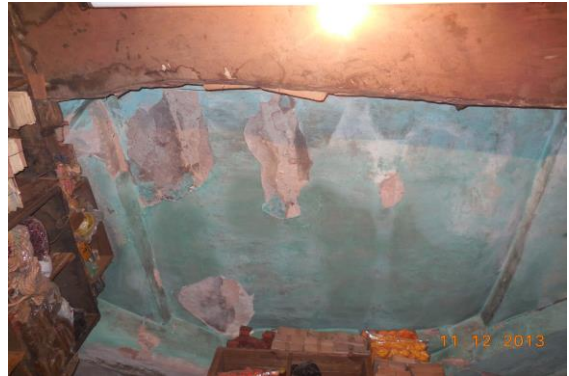
Photo 109

Peeling of Plaster on Roof of Part C of Shop No.168 of Ground Floor

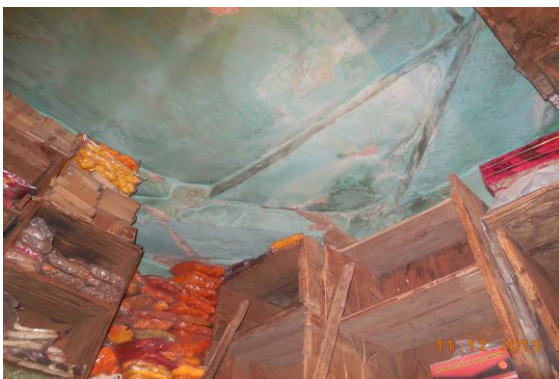
Photo 110

Peeling of Plaster on Roof of Part C of Shop No.168 of Ground Floor

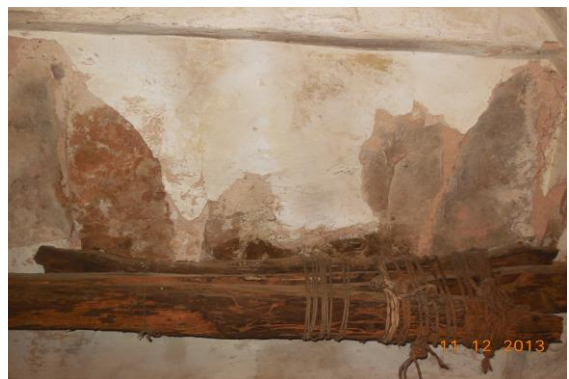
Photo 111

Peeling of Plaster on Roof of Part C of Shop No.168 of Ground Floor

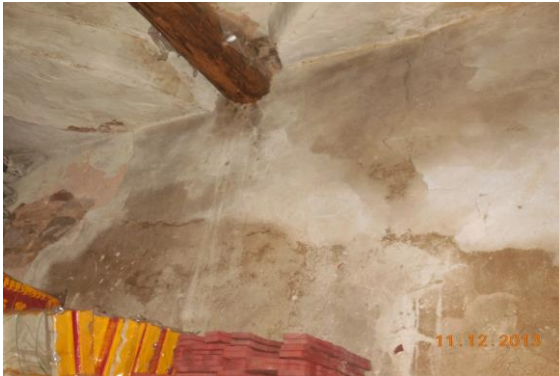
Photo 112

Peeling of Plaster on Roof of Part C of Shop No.168 of Ground Floor

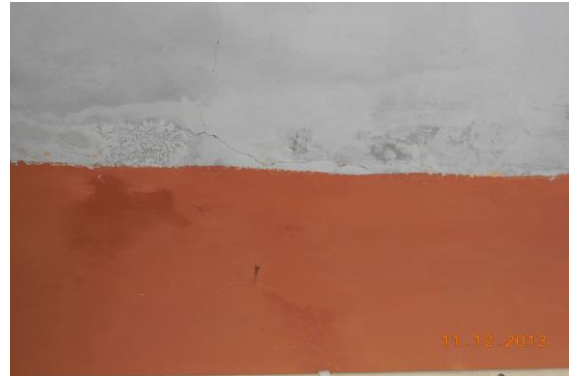
Photo 113

Plaster Crack on Roof of Varanda of Shop No.168 of Ground Floor

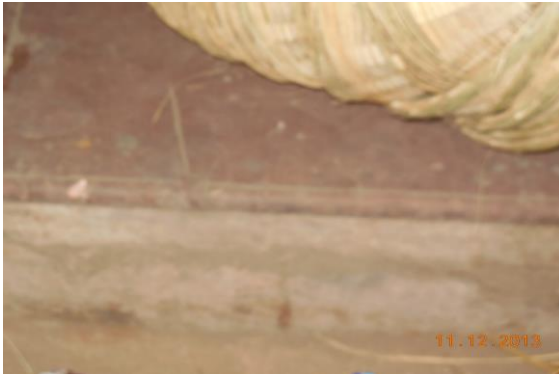
Photo 114

Damaged Portion on Floor of Varanda of Shop No.168 of Ground Floor

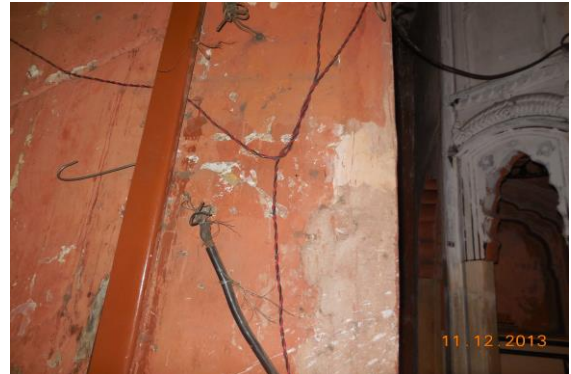
Photo 115

Damaged Portion on Outer Wall No.3 of Varanda of Shop No.168 of Ground Floor

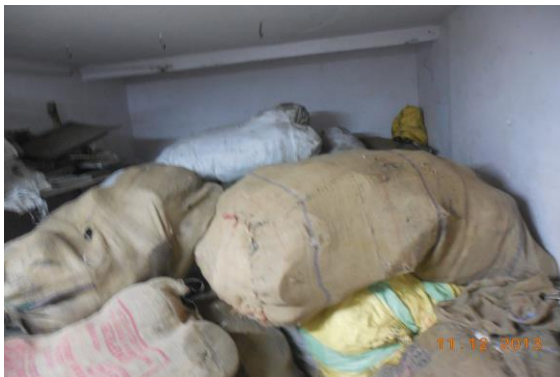
Photo 125

Wall No. 2 of Shop No.155 of Ground Floor Covered With Material

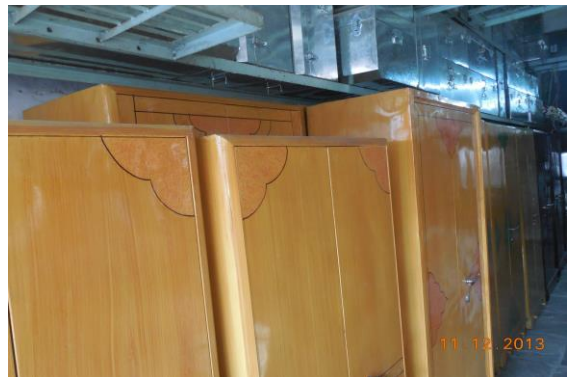
Photo 126

Wall No. 2 of Shop No.155 of Basement Covered With Material

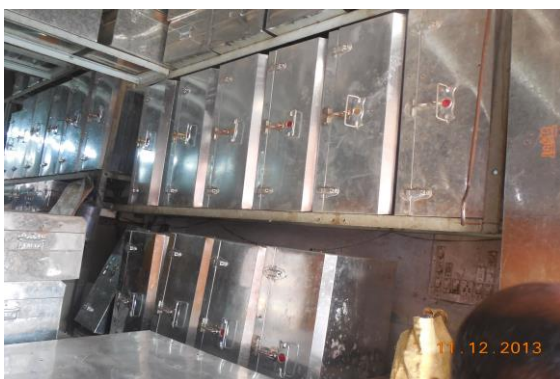
Photo 127

Wall No. 1 of Shop No.156 of Ground Floor Covered With Almira

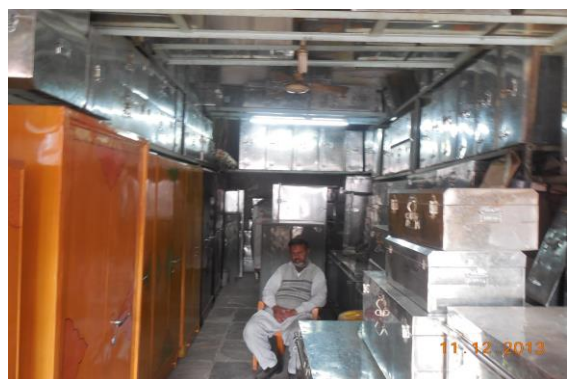
Photo 128

Wall No. 2 of Shop No.156 of Ground Floor Covered With Almira

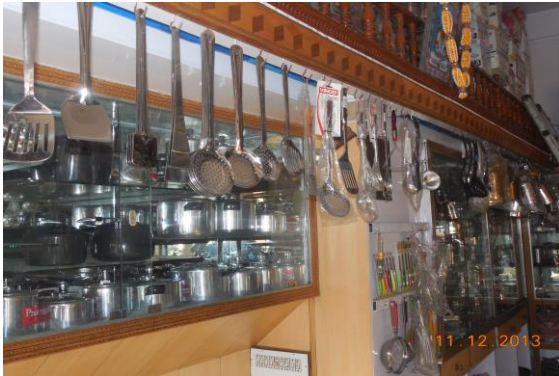
Photo 129

Wall No. 4 of Shop No.156 of Ground Floor

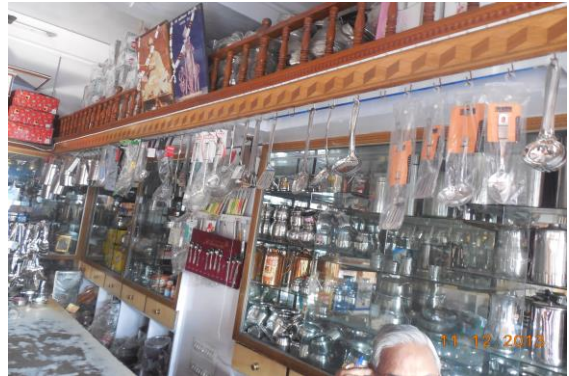
Photo 130
Wall No. 1 of Shop No.157 of Ground Floor

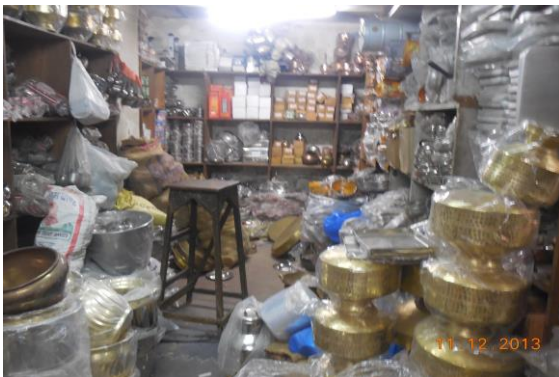
Photo 131
Wall No. 2 of Shop No.158 of Ground Floor Covered With Material

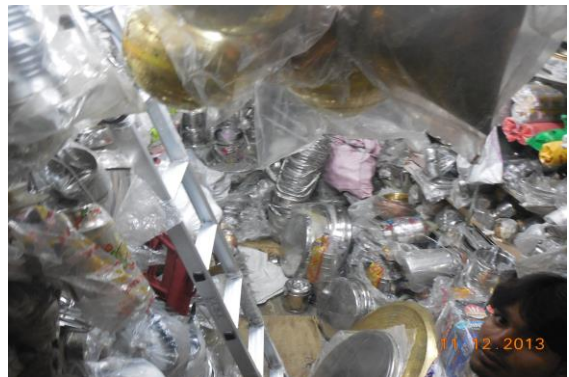
Photo 132
Wall No. 1 & 4 of Shop No.158 of Basement Covered With Wooden Rack & Material

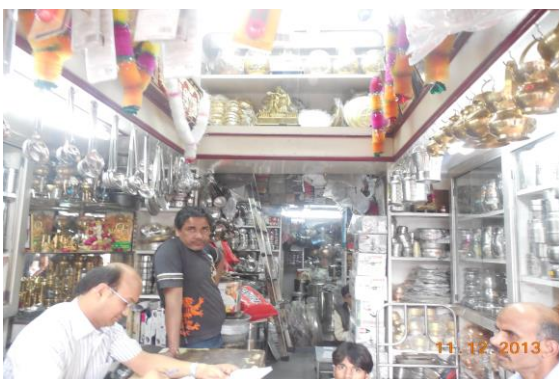
Photo 133
All walls of Shop No.159 of Basement Covered With Material

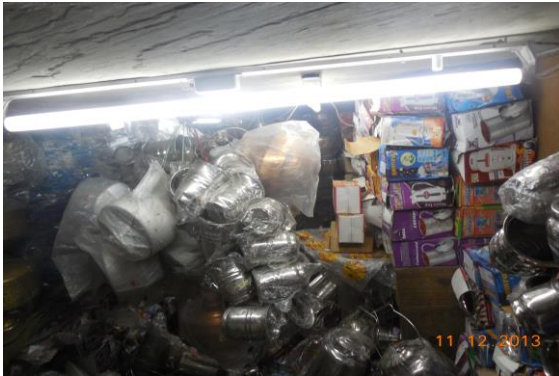
Photo 135
All walls & Roof of Shop No.160 of Ground Floor Covered With Material
