Pre Building Condition Survey Report

Name and Address of Structure :	Choti Chopar to Badi Chopar (UP Line)
---------------------------------	---------------------------------------

Name of the Project	Contract JMRC-UG1B “Design and Construction of Tunnel between Chandpole and Badi Chouper and reverse line by Shield TBM, Underground Metro Stations at Choti Chouper and Badi Chouper by Cut and Cover Methods on East West Corridor of Jaipur Metro Rail Corporation Limited .”	
Owner :

Shoping Complex - Shop No. 169-188
Tripolia Bazar
Jaipur
Unique ID: CC BC UP 0001

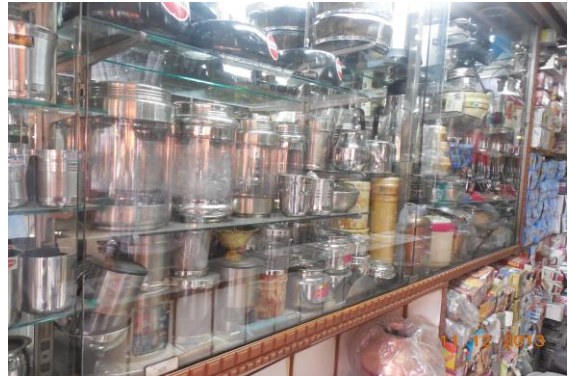
Photo 136

Wall No. All walls of Shop No.160 of Ground Floor Covered With Material

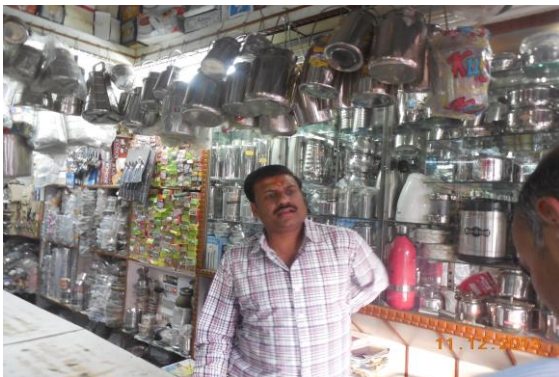
Photo 137

Wall No. 1 of Shop No.161 of Ground Floor Covered With Material

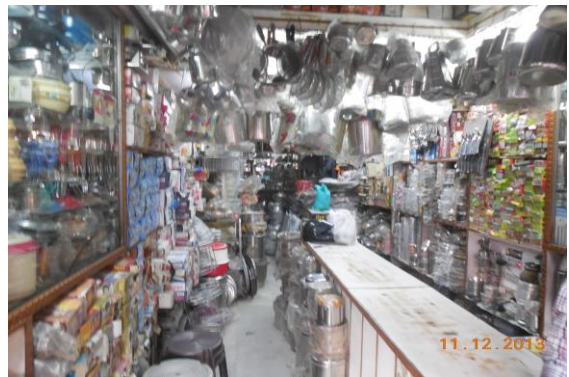
Photo 138

Wall No. 2 of Shop No.161 of Ground Floor Covered With Material

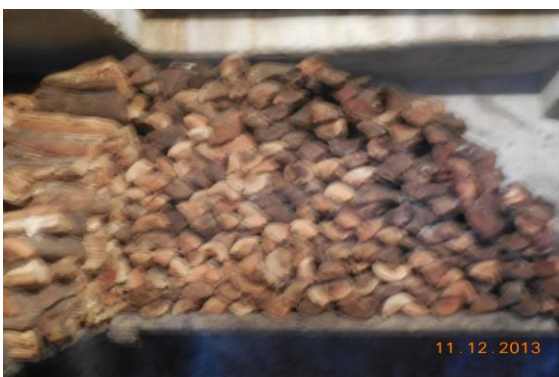
Photo 139

Wall No. 4 of Shop No.161 of Ground Floor Covered With Material

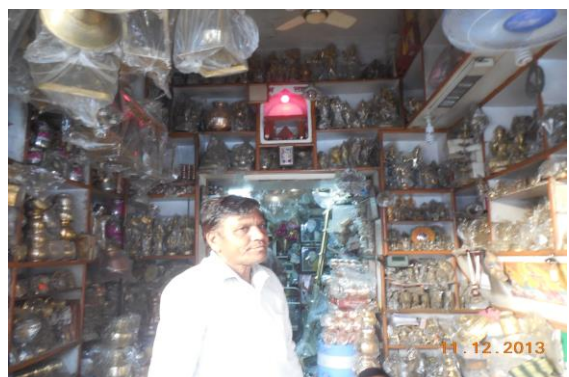
Photo 140

Wall No. 4 of Part C of Shop No.162 of Ground Floor

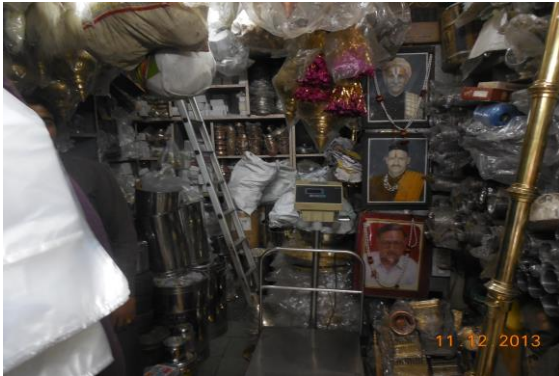
Photo 141

All walls of Part A of Shop No.163 of Ground Floor Covered With Wooden Racks & Material

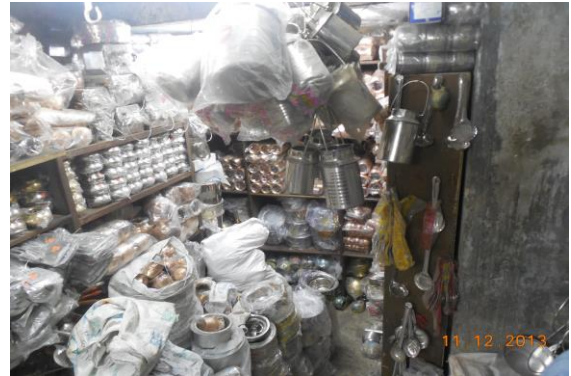
Photo 142

All walls of Part B of Shop No.163 of Ground Floor Covered With Wooden Racks & Material

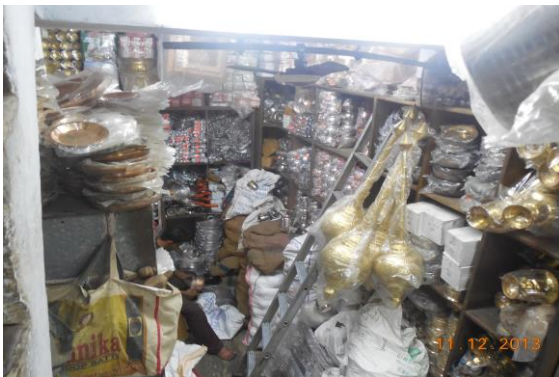
Photo 143

Wall No. 2 & 3 of Shop No.163 of Basement Covered With Material

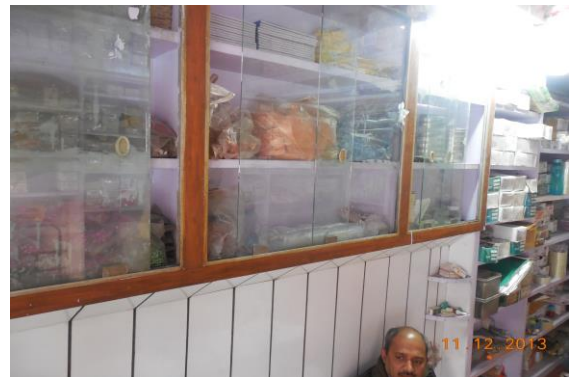
Photo 144

Wall No. 1 & 3 of Shop No.163 of Basement Covered With Material

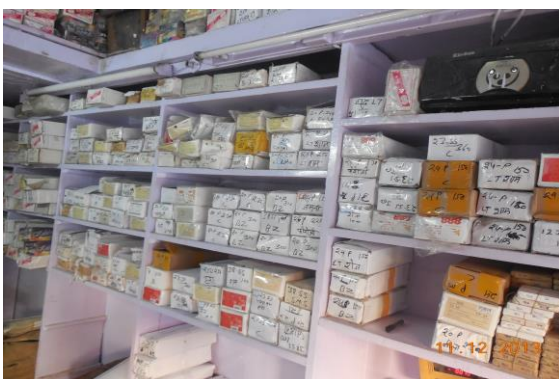
Photo 145

Wall No. 1 of Part A of Shop No.164 of Ground Floor Covered With Wooden Racks & Material

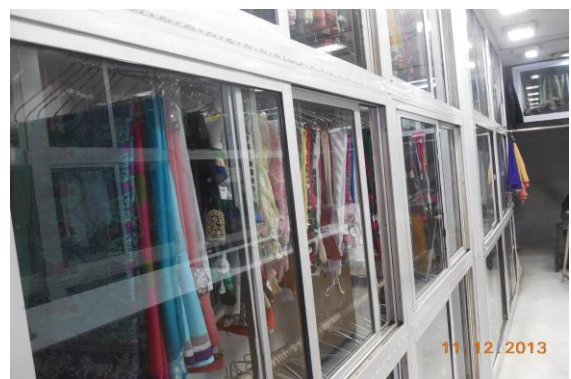
Photo 146

Wall No. 2 of Part A of Shop No.164 of Ground Floor Covered With Wooden Racks & Material

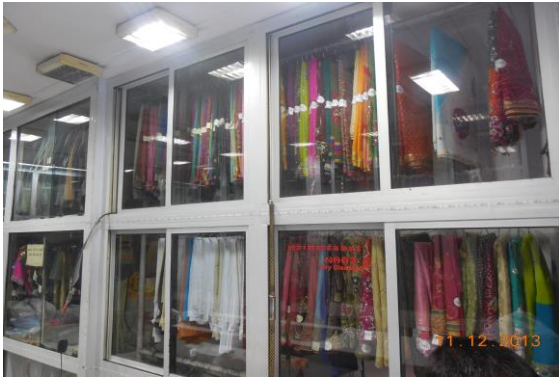
Photo 147

Wall No. 1 of Shop No.166 of Ground Floor Covered With Glass Rack & Material

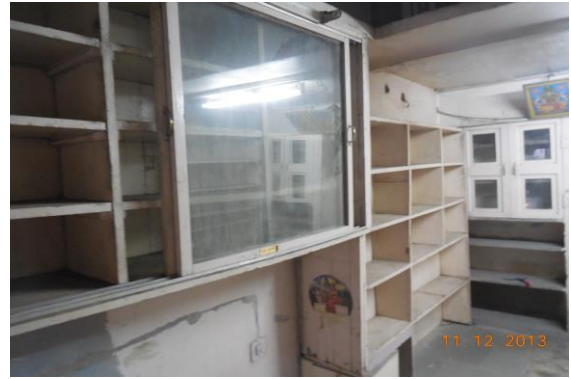
Photo 148

Wall No. 2 of Shop No.166 of Ground Floor Covered With Glass Rack & Material

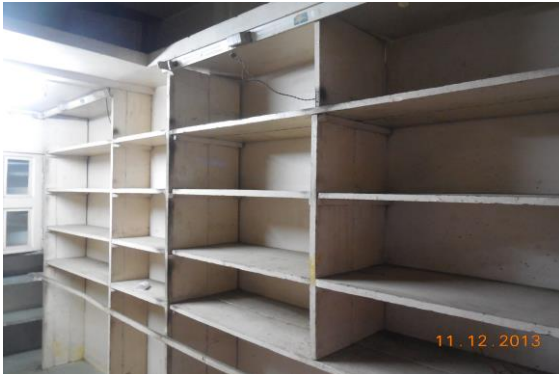
Photo 149

Wall No. 1 of Part A of Shop No.165 of Lower Ground Floor

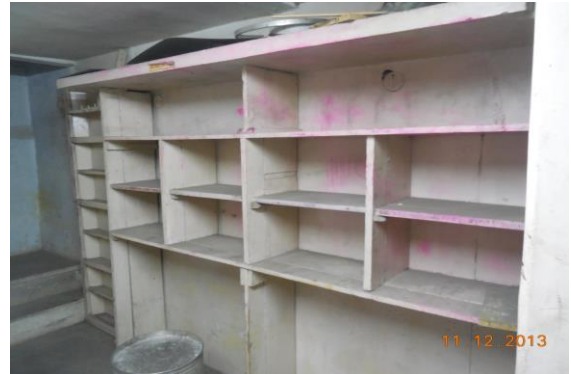
Photo 150

Wall No. 2 of Part A of Shop No.165 of Lower Ground Floor

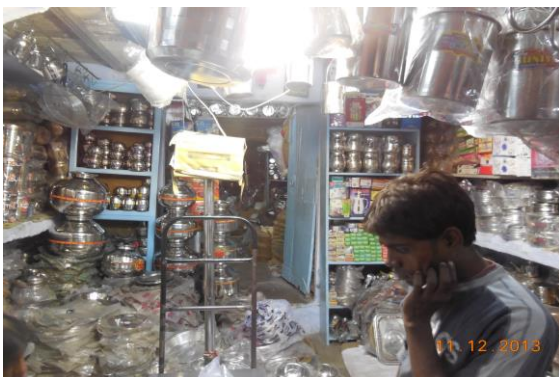
Photo 151

Wall No. 2 of Part B of Shop No.165 of Lower Ground Floor

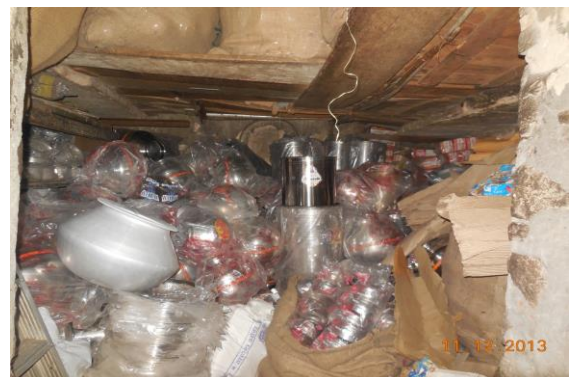
Photo 152

All walls of Part A of Shop No.167 of Ground Floor Covered With Material

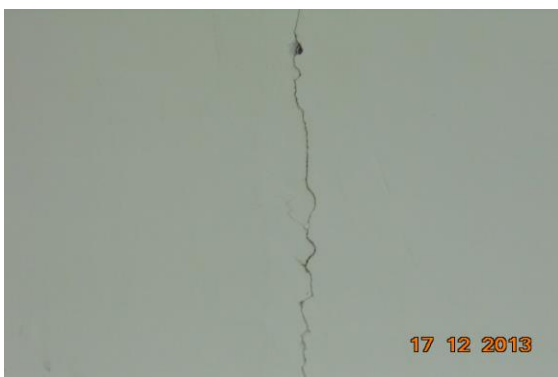
Photo 29
Inclined Crack on Wall No. 4 of Hall No. 2, Poornima Handicrafts, First Floor, Approx. Width = 0.35mm, Approx. Length = 2.5m. Distance from Wall No.1 = 0m, Height from Floor = 1m.

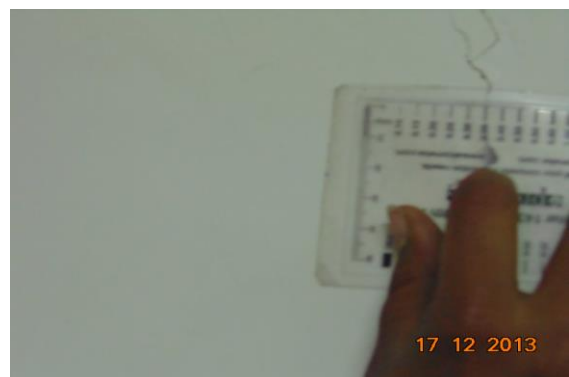
Photo 29A
Inclined Crack on Wall No. 4 of Hall No. 2, Poornima Handicrafts, First Floor, Approx. Width = 0.35mm, Approx. Length = 2.5m. Distance from Wall No.1 = 0m, Height from Floor = 1m.

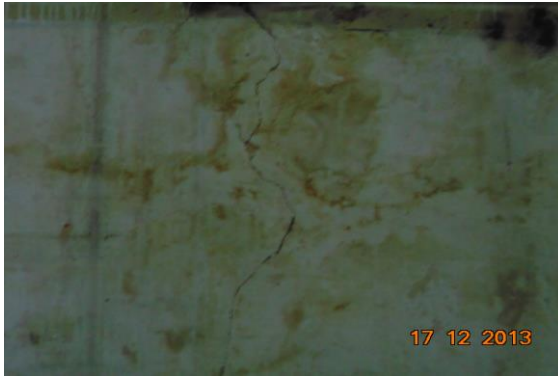
Photo 30

Inclined Crack on Wall No. 4 of Hall No. 4, Poornima Handicrafts, First Floor, Approx. Width = 0.6mm, Approx. Length = 1m. Distance from Wall No.1 = 4.5m, Height from Floor = 1.6m.

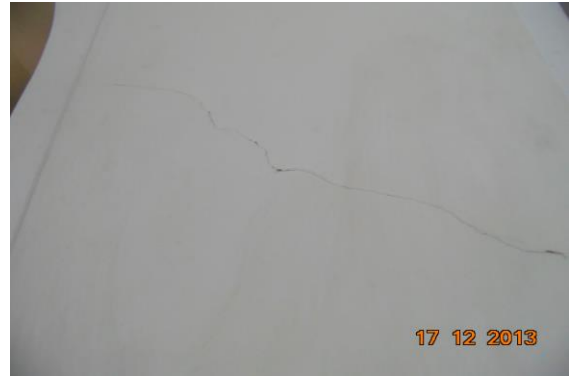
Photo 31

Inclined Crack on Wall No. 4 of Room No. 4, Poornima Handicrafts, First Floor, Approx. Width = 0.3mm, Approx. Length = 0.7m. Distance from Wall No.1 = 2.5m, Height from Floor = 1.8m.

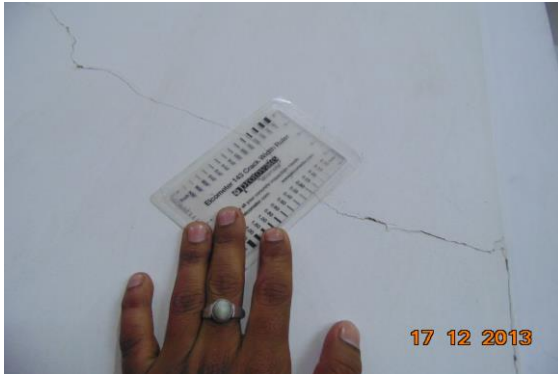
Photo 31A

Inclined Crack on Wall No. 4 of Room No. 4, Poornima Handicrafts, First Floor, Approx. Width = 0.3mm, Approx. Length = 0.7m. Distance from Wall No.1 = 2.5m, Height from Floor = 1.8m.

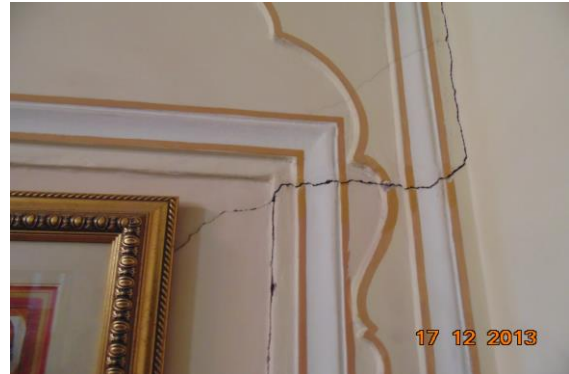
Photo 32

Inclined Crack on Wall No. 2 of Hall No. 5, Poornima Handicrafts, First Floor, Approx. Width = 2.5mm, Approx. Length = 5m. Distance from Wall No.3 = 1.5m, Height from Floor = 0m.

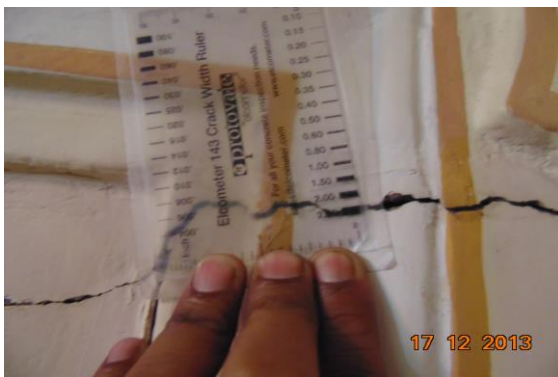
Photo 32A

Inclined Crack on Wall No. 2 of Hall No. 5, Poornima Handicrafts, First Floor, Approx. Width = 2.5mm, Approx. Length = 5m. Distance from Wall No.3 = 1.5m, Height from Floor = 0m.

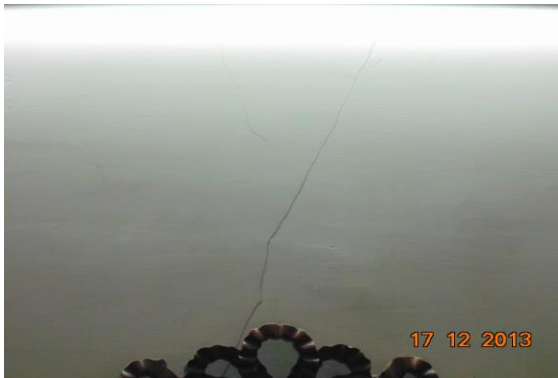
Photo 34

Inclined Crack on Wall No. 1 of Hall No. 6, Poornima Handicrafts, First Floor, Approx. Width = 0.8mm, Approx. Length = 1.8m. Distance from Wall No.3 = 1.5m, Height from Floor = 1.9m.

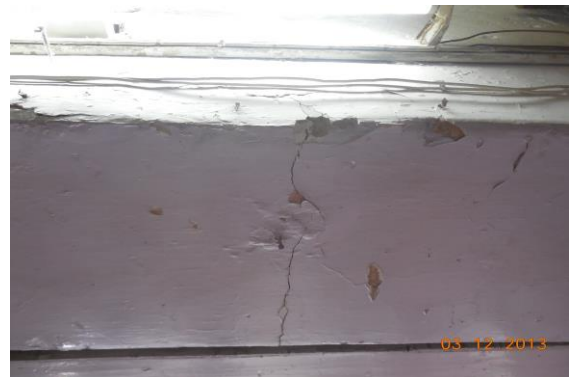
Photo 36

Horizontal Crack on Beam of Shop No. E 69, Ground Floor, Approx. Width = 0.5mm, Approx. Length = 0.7m. Distance from Wall No. 1 = 0.6m, Height from Floor = 2.4m.

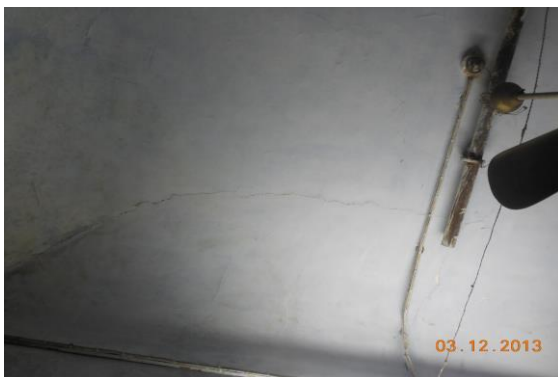
Photo 37

Inclined Crack on Roof of Part B, Shop No. E 63, Ground Floor, Approx. Width = 0.8mm, Approx. Length = 5m. Distance from Wall No. 1 = 0m, Height from Floor = 4m.

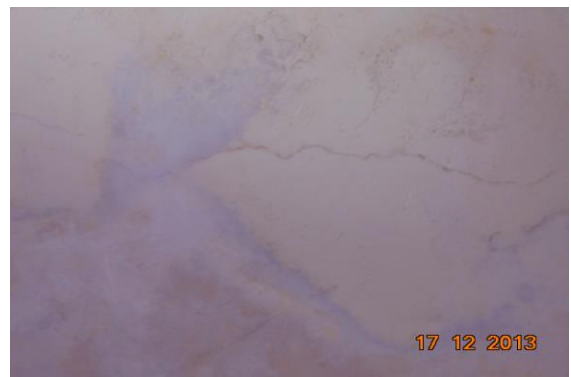
Photo 38

Peeling of Plaster on Roof of Shop No.114 A of Ground Floor

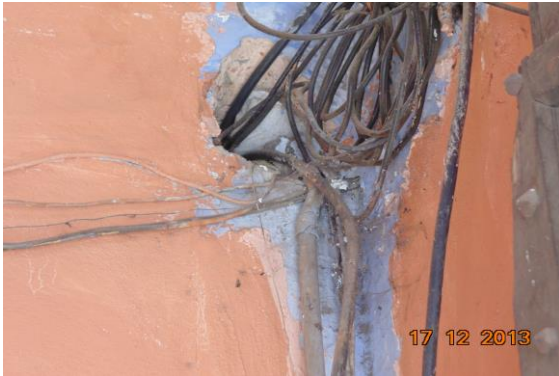
Photo 39

Damaged Portion on Wall No. 4 & Gate of Passage of Shop No.114 B of Ground Floor

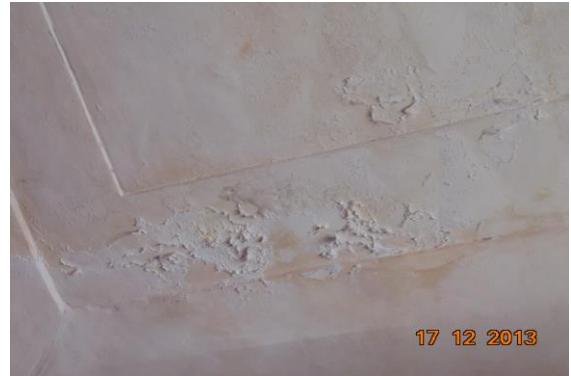
Photo 40

Dampness/Seepage on Roof

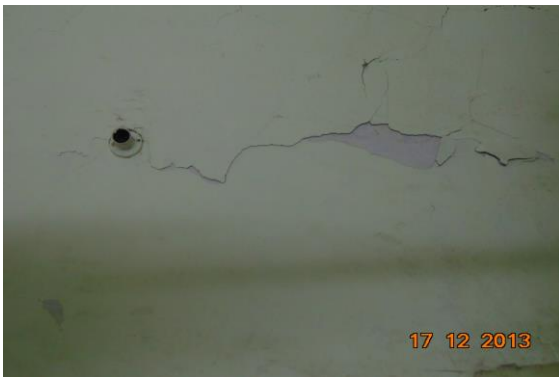
Photo 41

Peeling of Plaster on Wall No. 4 of Ladies Toilet of First Floor

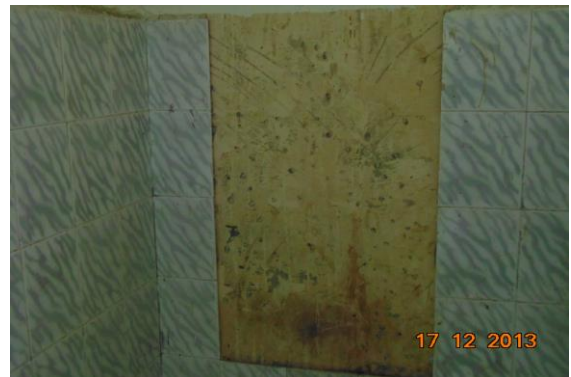
Photo 42

Damaged Portion on Wall No. 2 of Ladies Toilet of First Floor

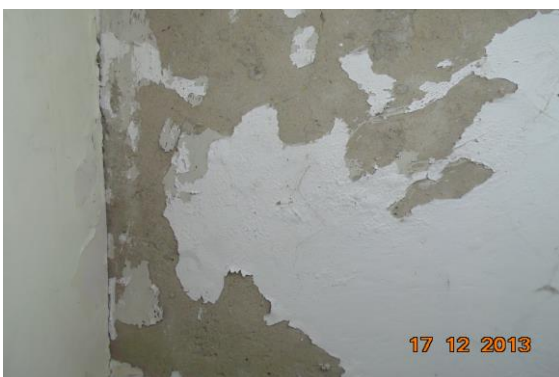
Photo 43

Peeling of Plaster on Roof of Ladies Toilet of First Floor

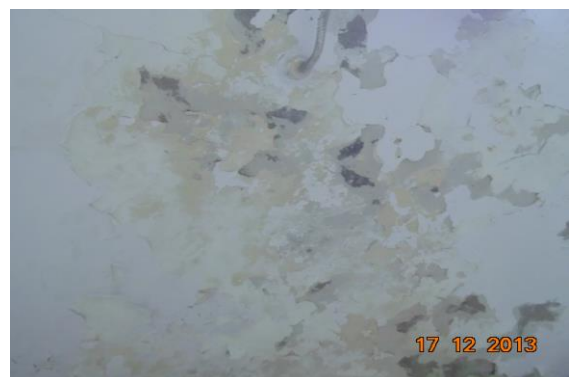
Photo 44

Dampness/Seepage on Roof of Hall No. 2 of Poornima Handicrafts, First Floor

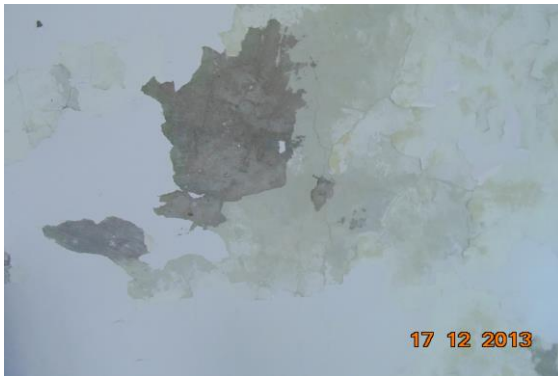
Photo 45

Dampness/Seepage on Roof of Hall No. 2 of Poornima Handicrafts, First Floor

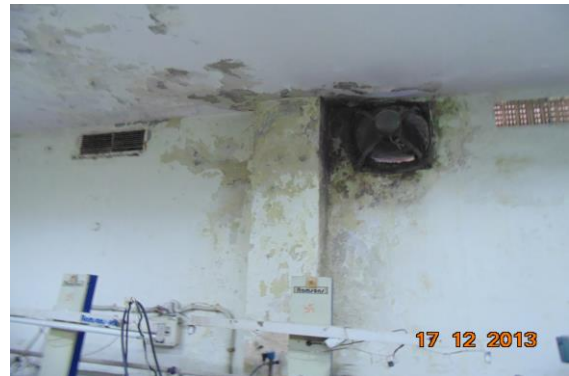
Photo 46

Dampness/Seepage on Wall No. 4 of Hall No. 2 of Poornima Handicrafts, First Floor

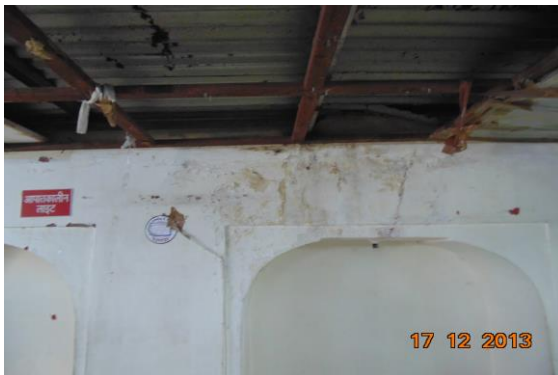
Photo 47

Dampness/Seepage on Wall No. 1 of Hall No. 1 of Poornima Handicrafts, First Floor

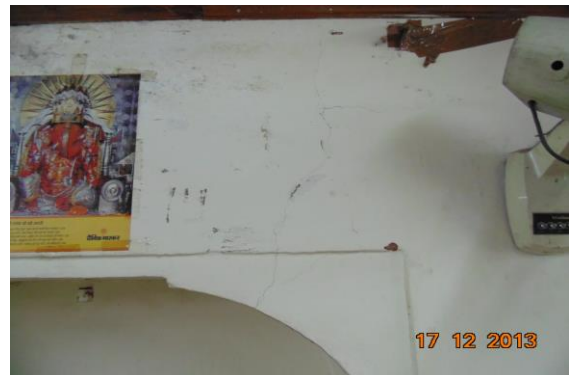
Photo 48

Peeling of Plaster on Wall No. 1 of Hall No. 1 of Poornima Handicrafts, First Floor

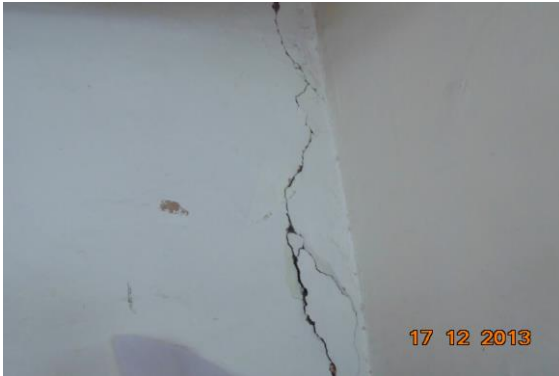
Photo 50

Damaged Portion on Wall No. 1 of Gents Toilet of First Floor

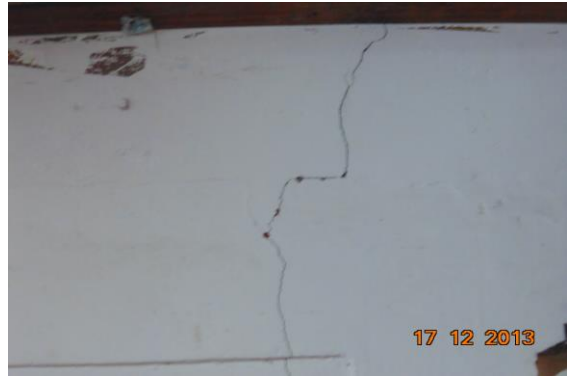
Photo 51

Peeling of Plaster on Wall No. 4 of Hall No. 1 of Poornima Handicrafts,
First Floor

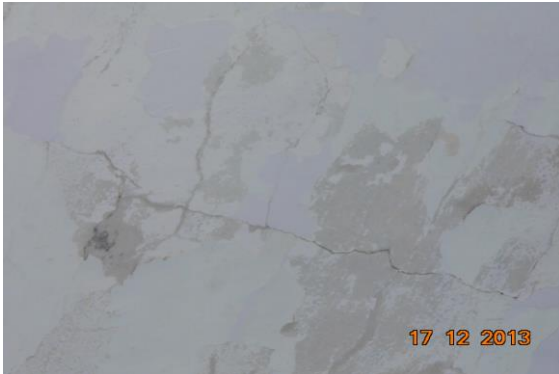
Photo 52

Peeling of Plaster on Wall No. 1 of Hall No. 1 of Poornima Handicrafts,
First Floor

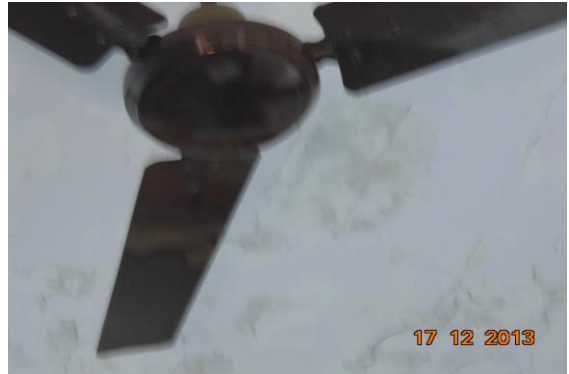
Photo 53

Peeling of Plaster on Roof of Hall No. 3 of Poornima Handicrafts, First
Floor

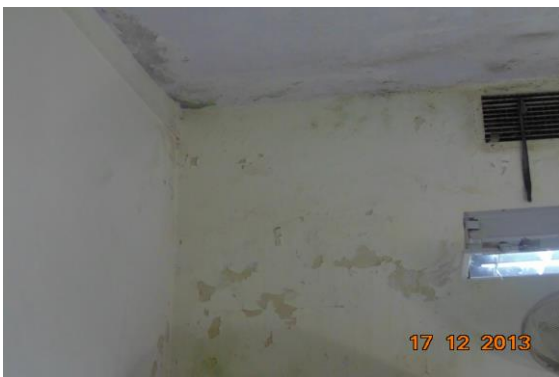
Photo 54

Dampness/Seepage on Roof of Hall No. 3 of Poornima Handicrafts,
First Floor

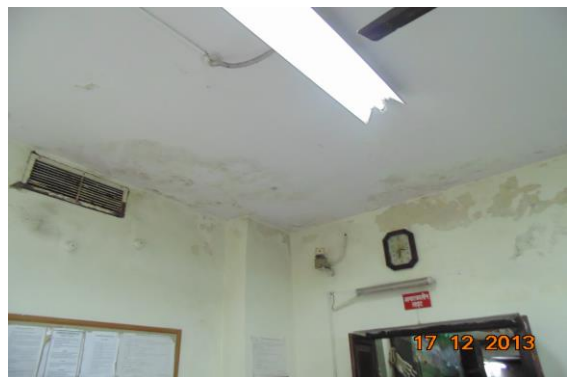
Photo 55

Dampness/Seepage on Wall No. 4 of Hall No. 3 of Poornima
Handicrafts, First Floor

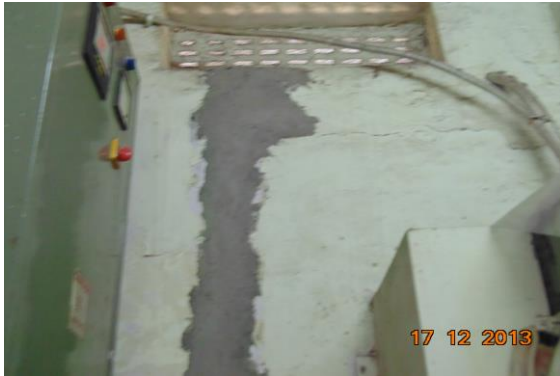
Photo 56

Dampness/Seepage on Wall No. 2 & Roof of Hall No. 3 of Poornima
Handicrafts, First Floor

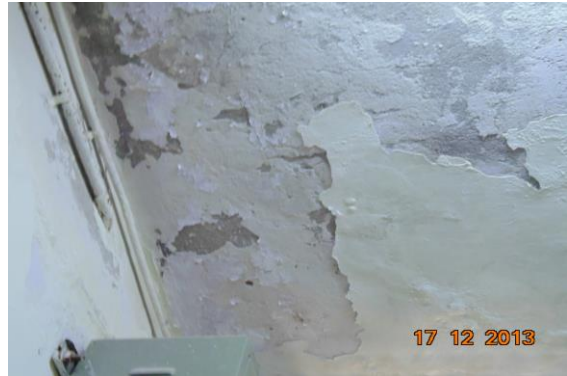
Photo 57
Peeling of Plaster on Wall No. 4 of Lobby of First Floor

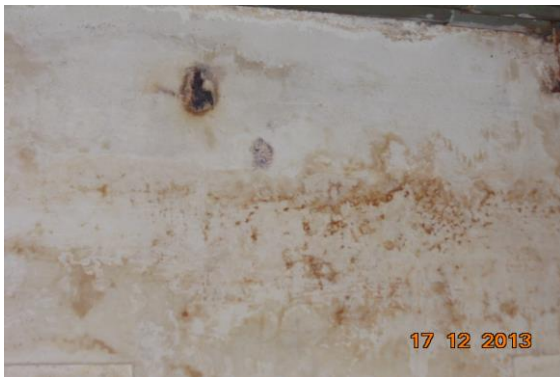
Photo 58
Dampness/Seepage on Roof of Lobby of First Floor

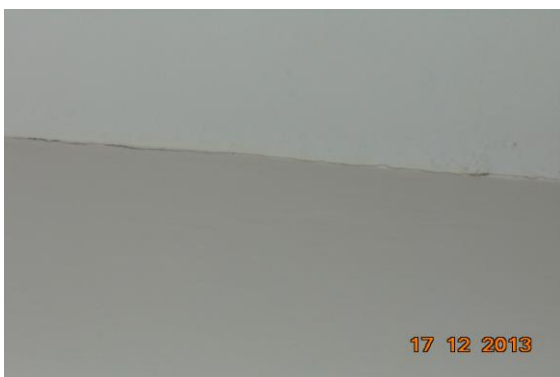
Photo 60
Peeling of Plaster on Wall No. 4 of Inspect Room of First Floor

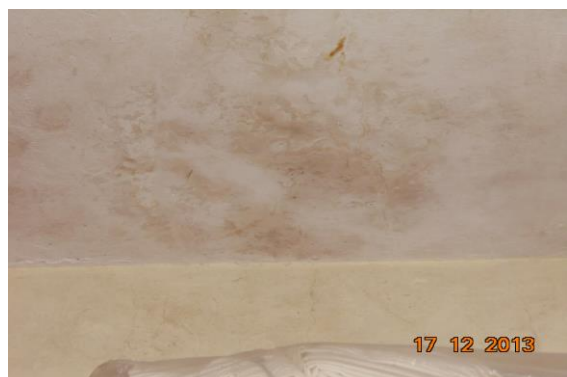
Photo 61
Peeling of Plaster on Roof of Inspect Room of First Floor

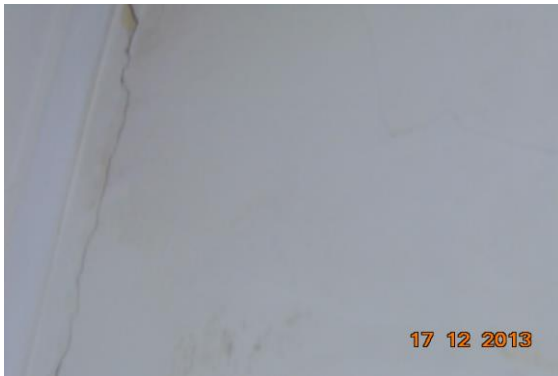
Photo 62
Dampness/Seepage on Roof of Store of First Floor

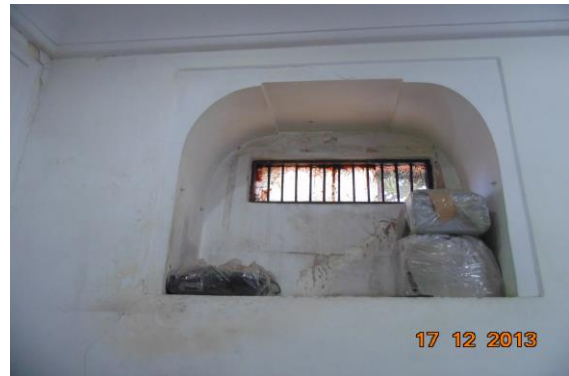
Photo 63

Peeling of Plaster on Wall No. 4 of Room No. 4 of Poornima Handicrafts, First Floor

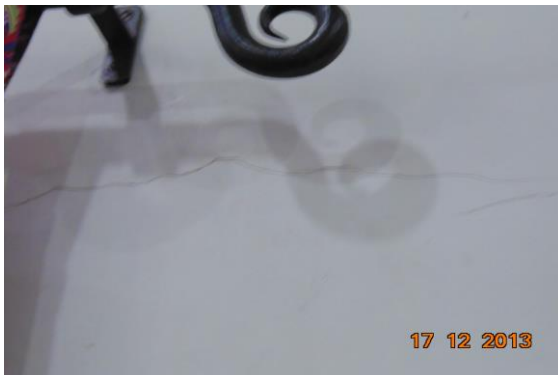
Photo 64

Dampness/Seepage on Wall No. 4 of Room No. 4 of Poornima Handicrafts, First Floor

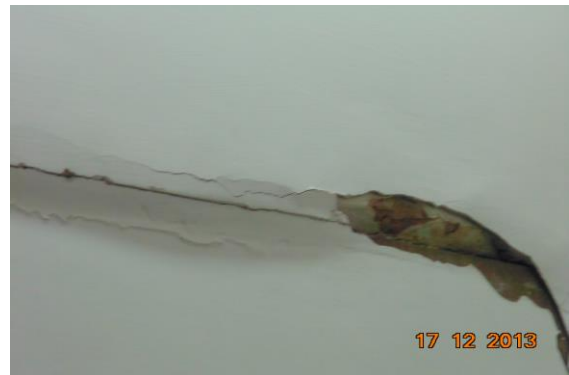
Photo 65

Peeling of Plaster on Wall No. 3 of Room No. 4 of Poornima Handicrafts, First Floor

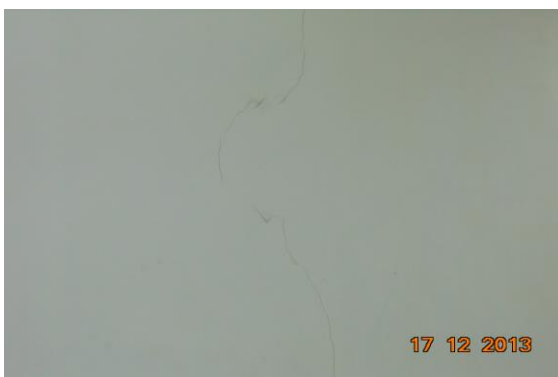
Photo 66

Peeling of Plaster on Wall No. 4 of Room No. 5 of Poornima Handicrafts, First Floor

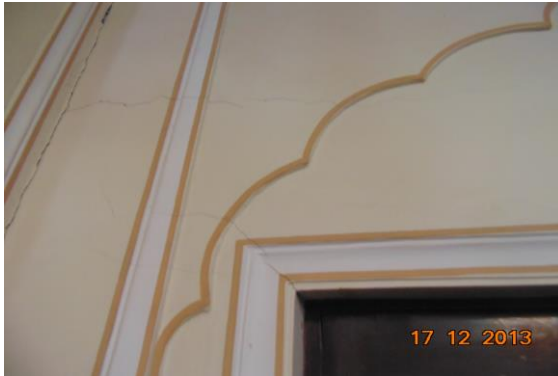
Photo 68

Peeling of Plaster on Wall No. 1 of Room No. 5 of Poornima Handicrafts, First Floor

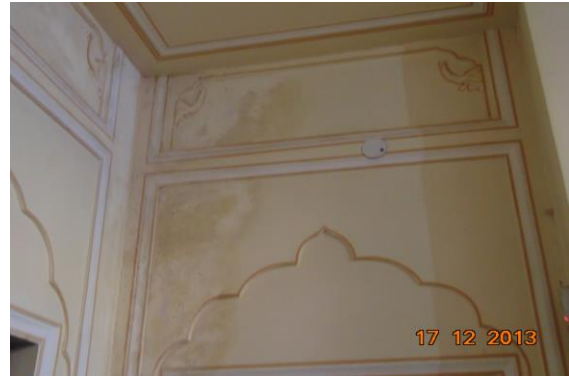
Photo 69

Peeling of Plaster on Wall No. 3 of Hall No. 5 of Poornima Handicrafts, First Floor

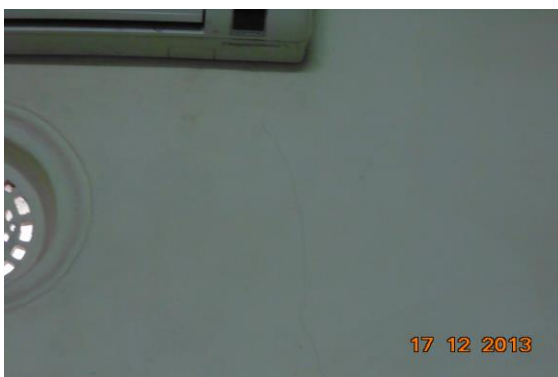
Photo 72

Peeling of Plaster on Wall No. 1 of Room No. 7 of Poornima Handicrafts, First Floor

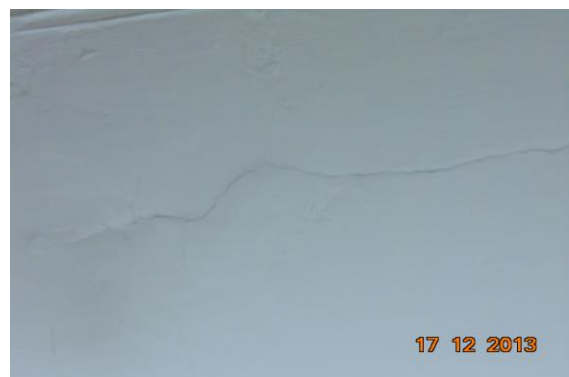
Photo 73

Peeling of Plaster on Wall No. 4 of Room No. 8 of Poornima Handicrafts, First Floor

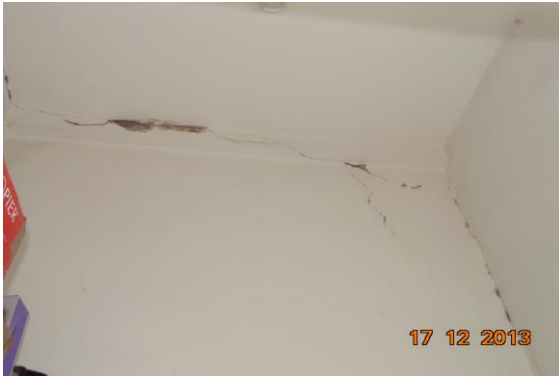
Photo 74

Peeling of Plaster on Roof of Room No. 8 of Poornima Handicrafts, First Floor

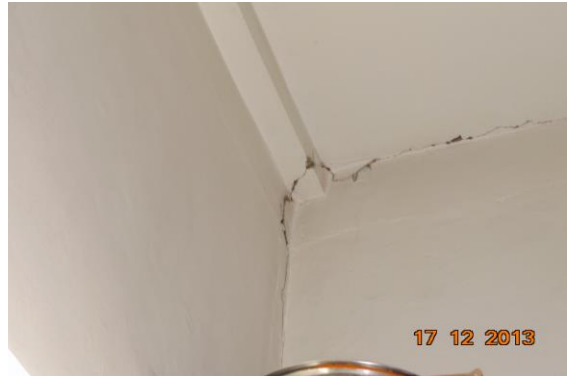
Photo 75
Peeling of Plaster on Wall No. 4 of Kitchen of First Floor

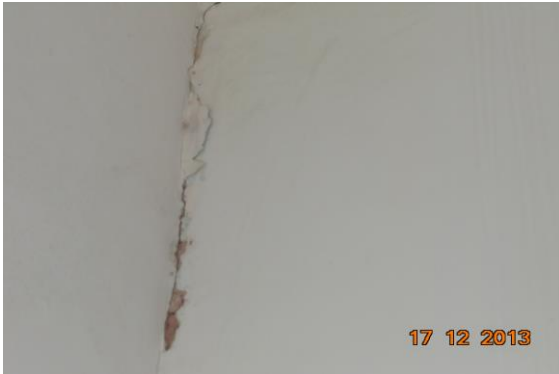
Photo 76
Peeling of Plaster on Wall No. 1 & 3 of Kitchen of First Floor

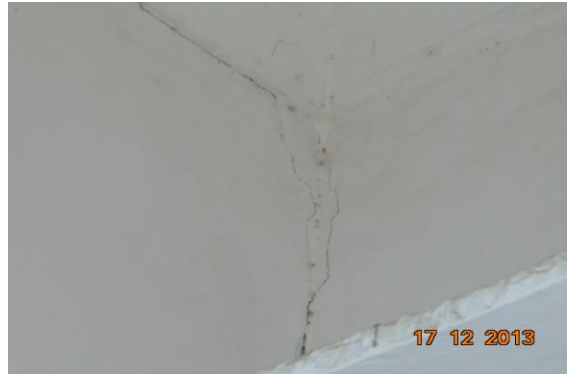
Photo 77
Peeling of Plaster on Wall No. 4 of Toilet No. 1 of Poornima Handicrafts, First Floor

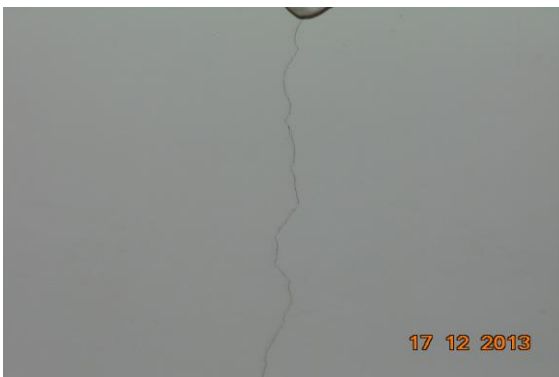
Photo 78
Peeling of Plaster on Wall No. 4 of Toilet No. 1 of Poornima Handicrafts, First Floor

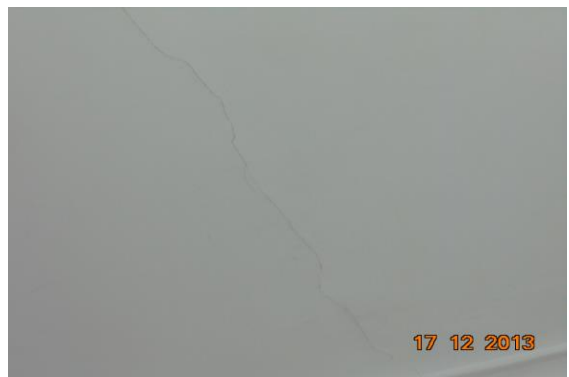
Photo 79
Peeling of Plaster on Roof of Hall No. 6 of Poornima Handicrafts, First Floor

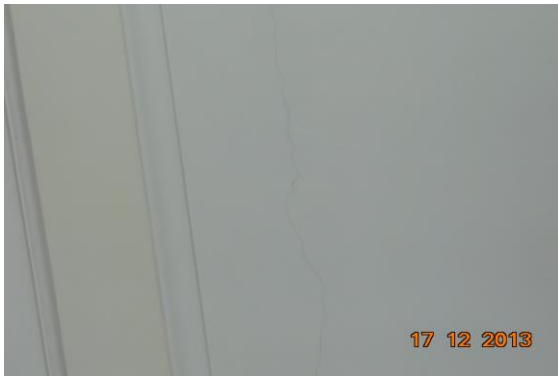
Photo 80
Peeling of Plaster on Roof of Hall No. 6 of Poornima Handicrafts, First Floor

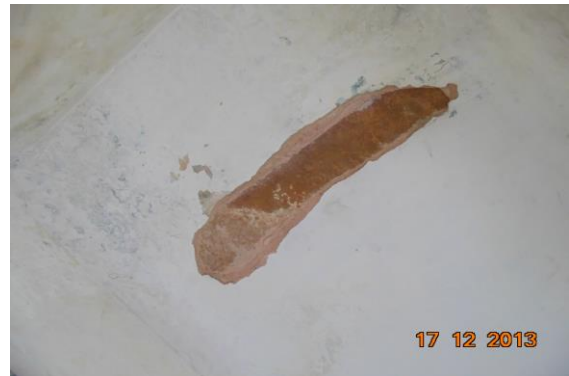
Photo 81

Peeling of Plaster on Roof of Hall No. 6 of Poornima Handicrafts, First Floor

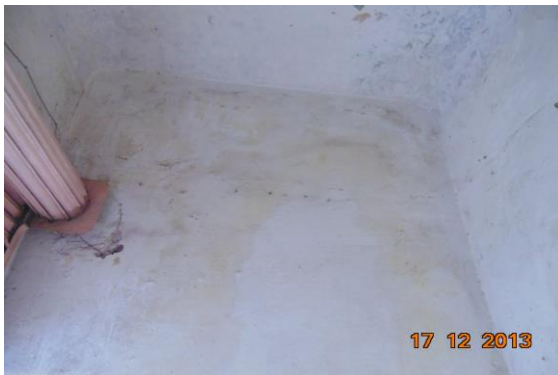
Photo 82

Peeling of Plaster on Roof of Part A of Shop E-57 of Ground Floor

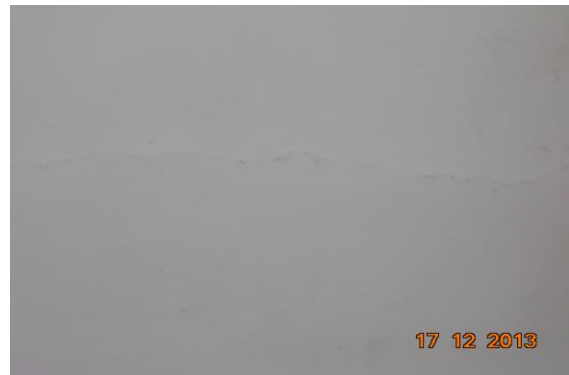
Photo 83

Dampness/Seepage on Wall No. 1 & Roof of Part A of Shop E-57 of Ground Floor

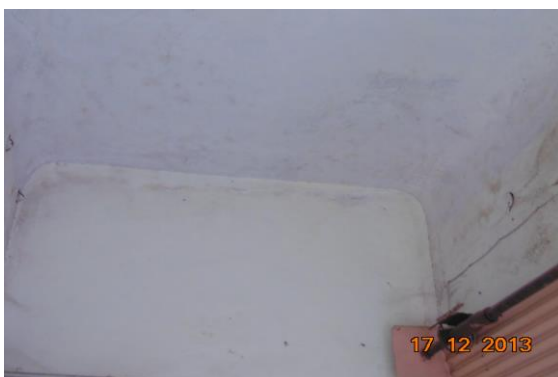
Photo 84

Peeling of Plaster on Roof of Part A of Shop E-57 of Ground Floor

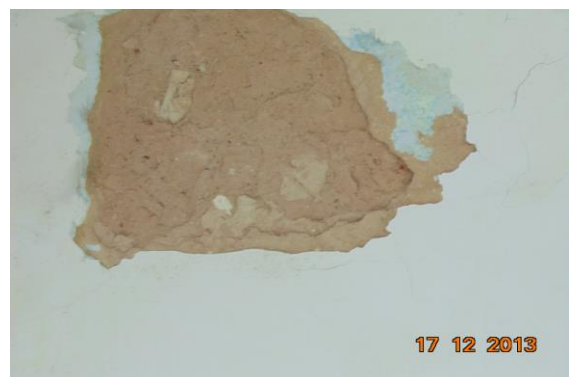
Photo 85

Dampness/Seepage on Wall No 2, 3 & 4 & Roof, of Part A of Shop E-57 of Ground Floor

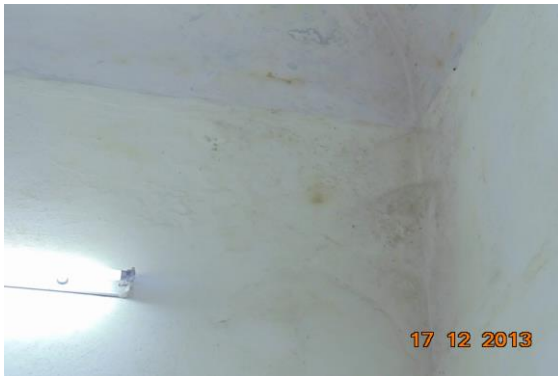
Photo 86

Peeling of Plaster on Roof of Part B of Shop E-57 of Ground Floor

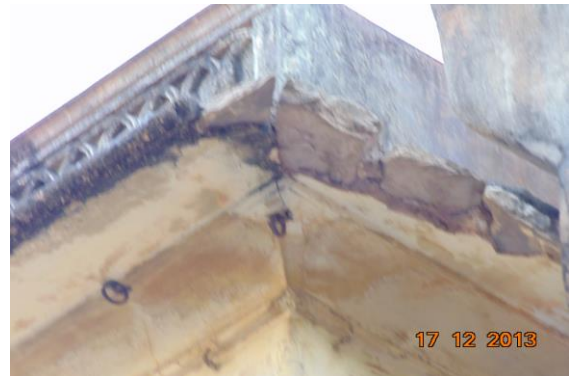
Photo 87

Peeling of Plaster on Wall No. 1, 3 & Roof of Part B of Shop E-57 of Ground Floor

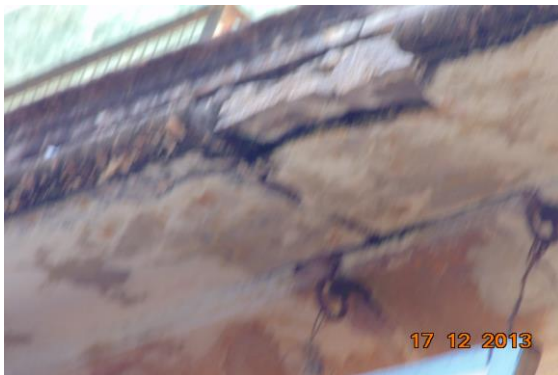
Photo 88

Damaged Portion on Front side Shade of Part B of Shop E-57 of Ground Floor

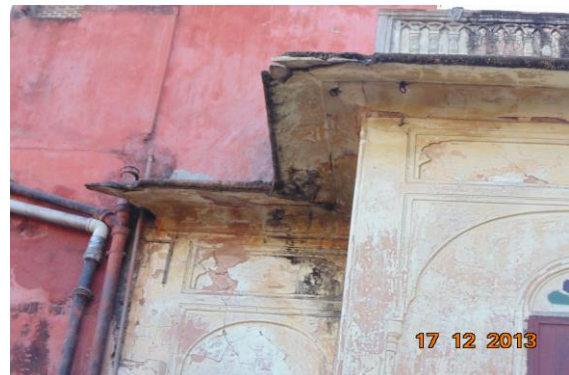
Photo 89

Damaged Portion on Front side Shade of Part B of Shop E-57 of Ground Floor

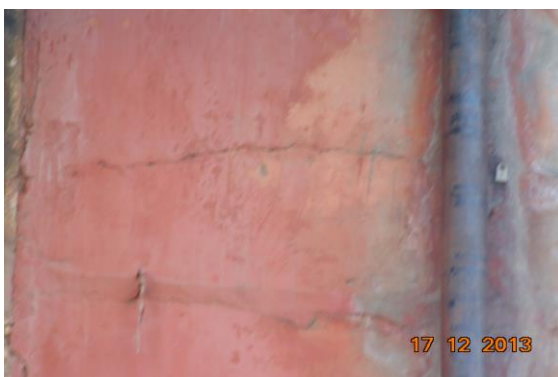
Photo 90

Damaged Portion on Front side Shade of Poornima Handicrafts of First Floor

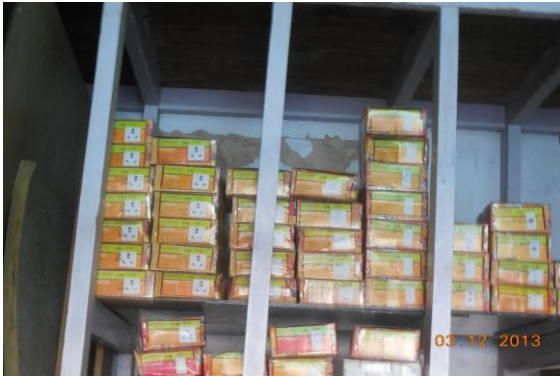
Photo 92

Peeling of Plaster on Wall No. 1 of Shop No. E 70 of Ground Floor

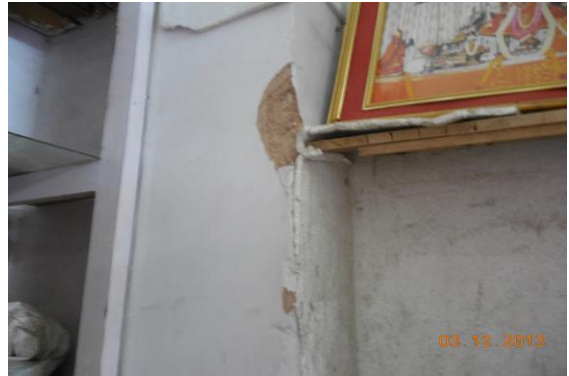
Photo 93

Peeling of Plaster on Wall No. 4 of Shop No. E 69 of Ground Floor

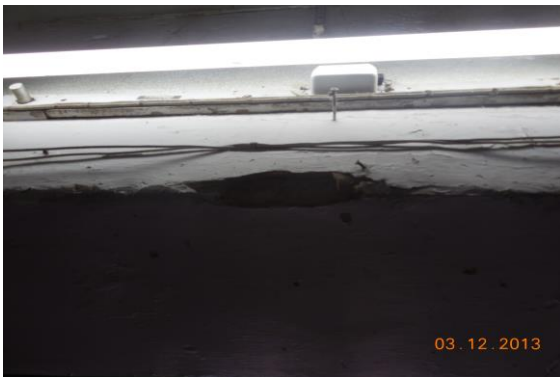
Photo 94

Peeling of Plaster on Wall No. 2 of Shop No. E 69 of Ground Floor

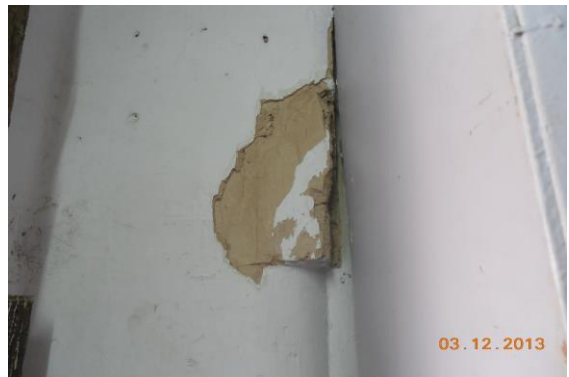
Photo 95

Peeling of Plaster on Beam of Shop No. E 69 of Ground Floor

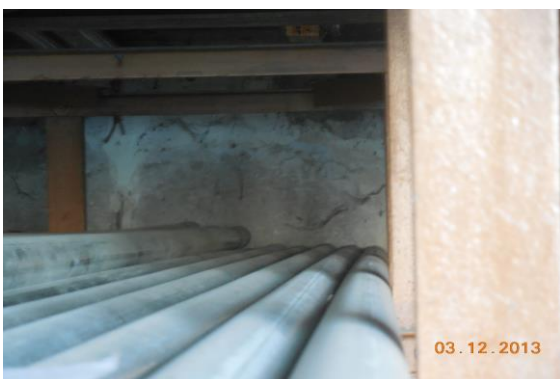
Photo 96

Peeling of Plaster on Wall No. 1 of Shop No. E 69 of Ground Floor

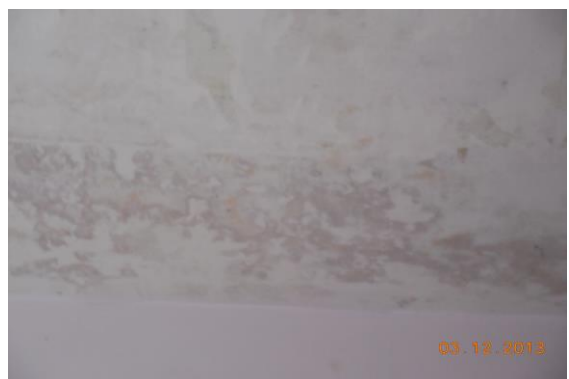
Photo 97

Dampness/Seepage on Wall No. 4 of Shop No. E 69 of Ground Floor

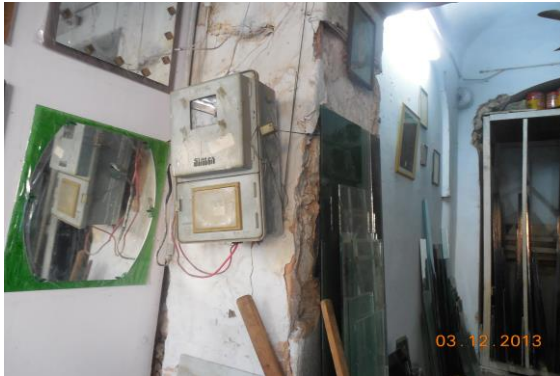
Photo 98

Dampness/Seepage on Roof

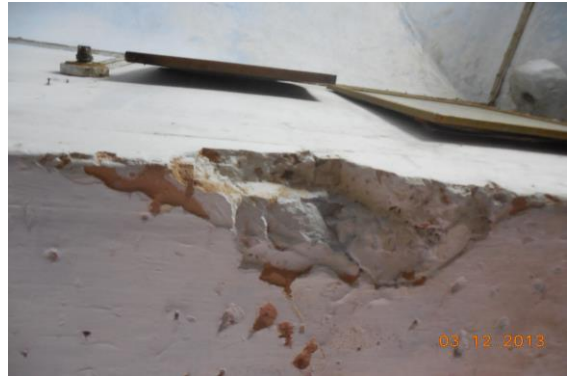
Photo 99

Peeling of Plaster on Wall No. 2 of Part A of Shop No. E 63, Ground Floor

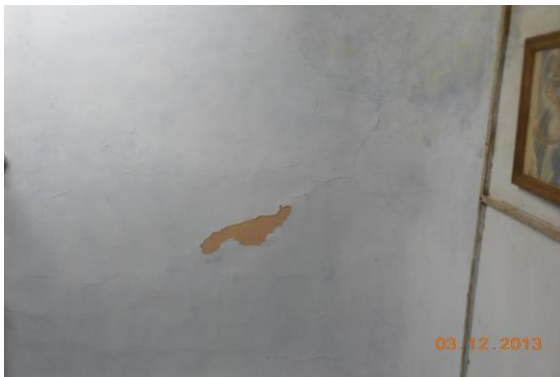
Photo 100

Peeling of Plaster on Roof & Beam of Part A of Shop No. E 63, Ground Floor

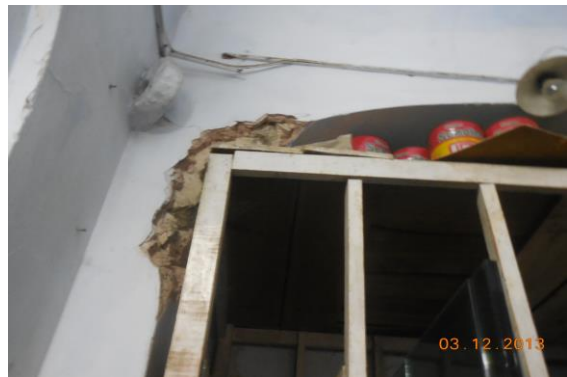
Photo 101

Peeling of Plaster on Roof of Part B of Shop No. E 63, Ground Floor

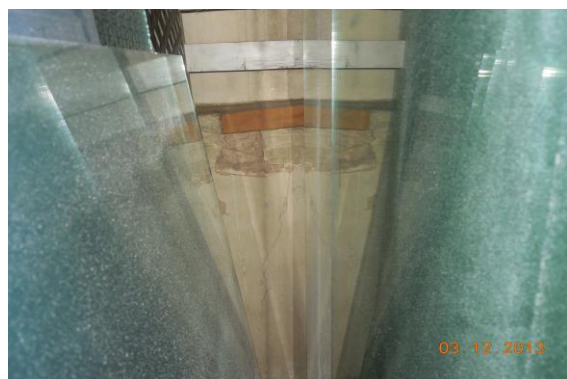
Photo 103

Peeling of Plaster on Wall No. 4 of Part C of Shop No. E 63, Ground Floor

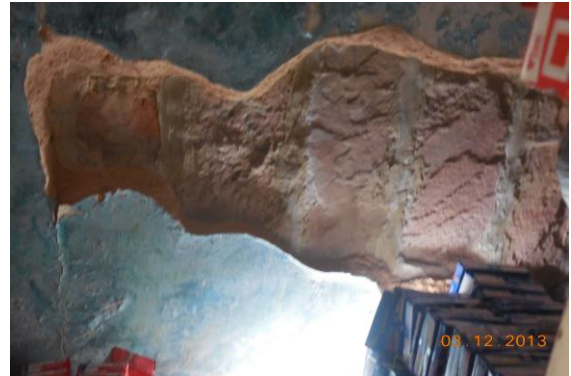
Photo 105
Peeling of Plaster on External Wall No. 3 of Shop No. E 60 of Ground Floor

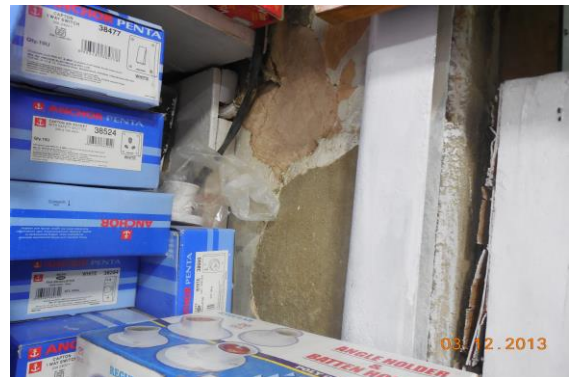
Photo 107
Peeling of Plaster on Roof of Shop No. E 60 of Ground Floor

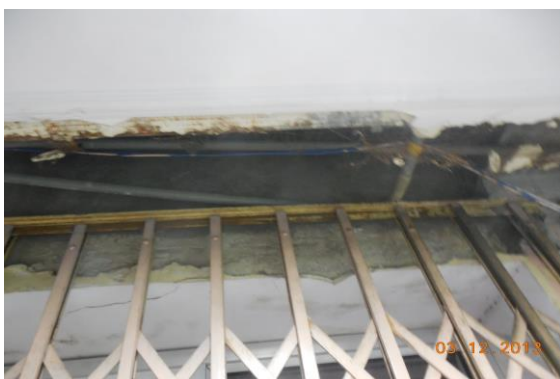
Photo 108
Peeling of Plaster on Wall No. 4 of Part A of Shop No. E 59, Ground Floor

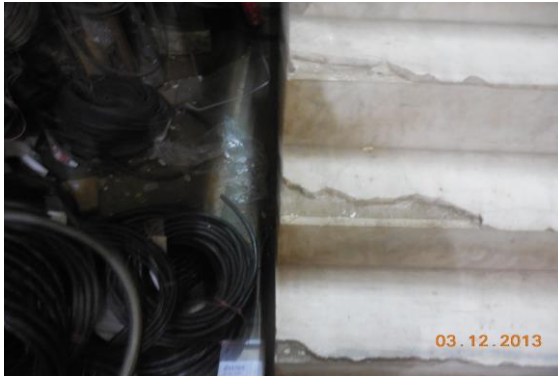
Photo 110
Peeling of Plaster on Wall No. 4 of Shop No. E 144, Basement

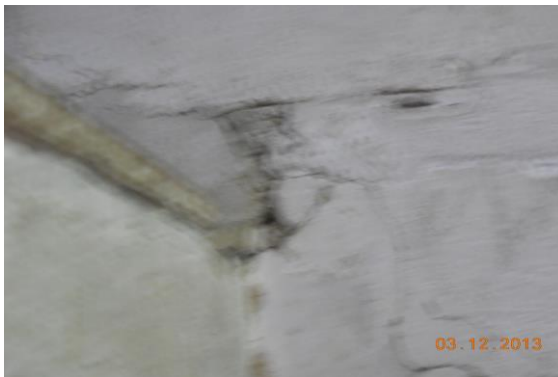
Photo 112
Peeling of Plaster on Roof of Part B of Shop No. D 54, Ground Floor

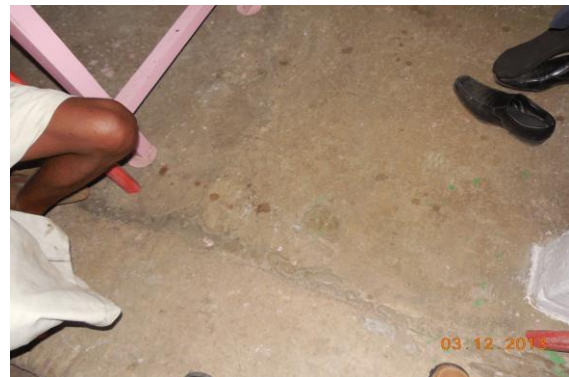
Photo 113
Peeling of Plaster of Stair of Shop No. D 54, Ground Floor

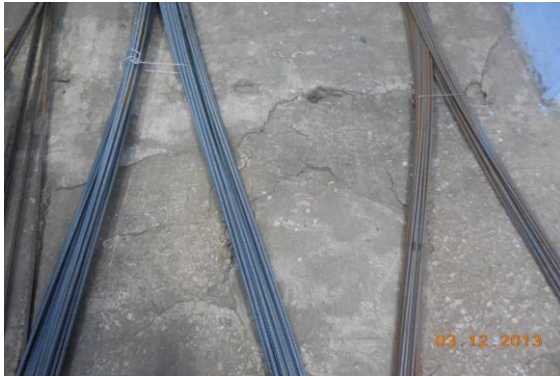
Photo 116
Peeling of Plaster on Floor of Part A of Shop No. D 53, Ground Floor

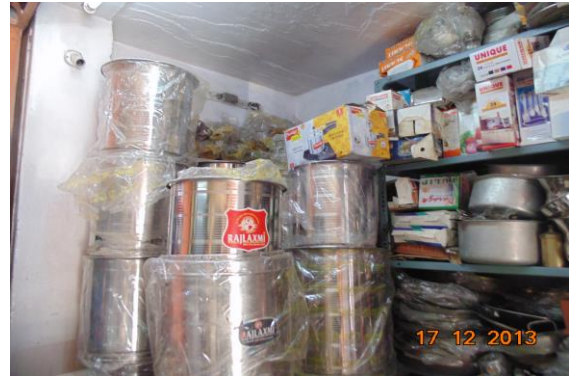
Photo 117

Peeling of Plaster on Floor of Part A of Shop No. D 53, Ground Floor

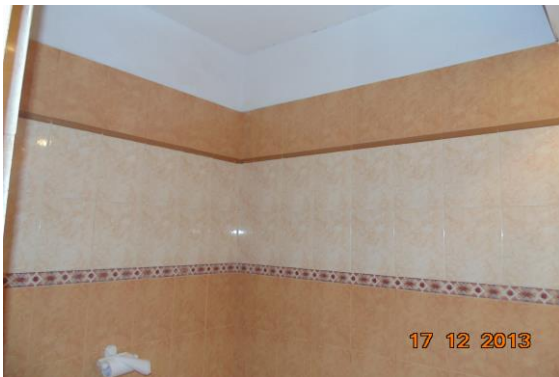
Photo 131
All Walls of Toilet No. 2 of Poornima Handicrafts, First Floor Covered With Tiles

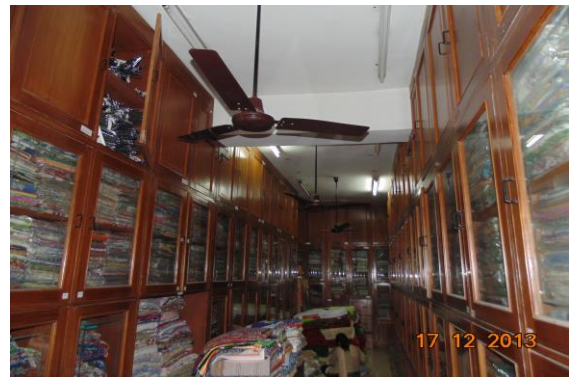
Photo 132
All Walls of Room No. 10 of Poornima Handicrafts, First Floor Covered With Wooden Work
