Pre Building Condition Survey Report

Name and Address of Structure :	Choti Chopar to Badi Chopar (UP Line)
---------------------------------	---------------------------------------

Name of the Project	Contract JMRC-UG1B “Design and Construction of Tunnel between Chandpole and Badi Chouper and reverse line by Shield TBM, Underground Metro Stations at Choti Chouper and Badi Chouper by Cut and Cover Methods on East West Corridor of Jaipur Metro Rail Corporation Limited .”	
Owner :

Shoping Complex - Shop No. 169-188
Tripolia Bazar
Jaipur
Unique ID: CC BC UP 0001

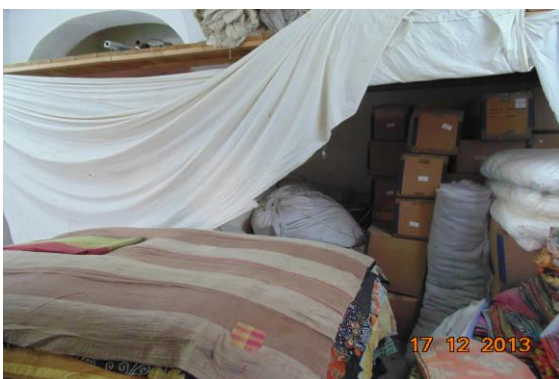
Photo 133
Wall No. 4 of Part B of Shop E-57 of Ground Floor Covered With Material

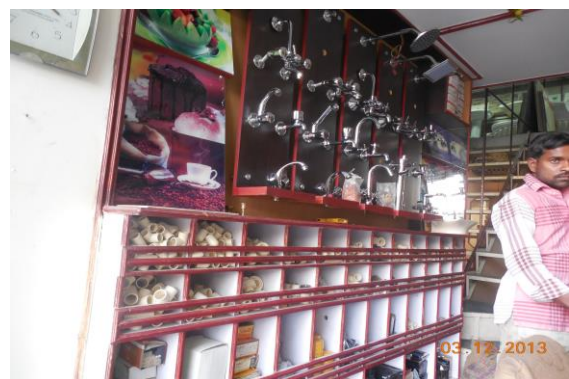
Photo 134
Wall No. 1 of Shop No. E 71 of Ground Floor Covered with Material

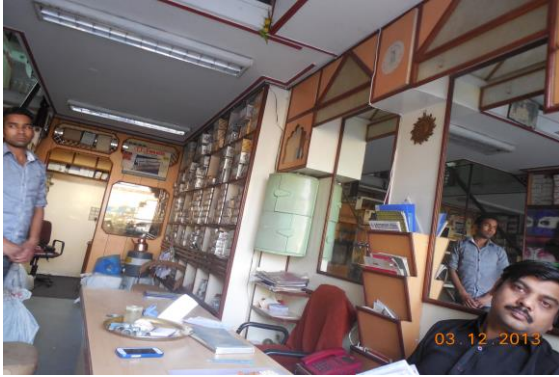
Photo 135

Wall No. 2 of Shop No. E 71 of Ground Floor Covered with Material

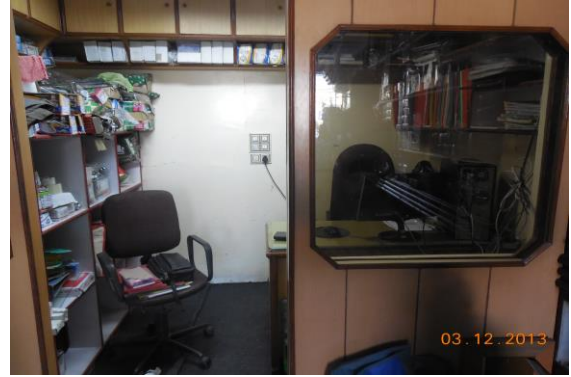
Photo 136

Wall No. 4 of Shop No. E 71 of Ground Floor Covered with Glass

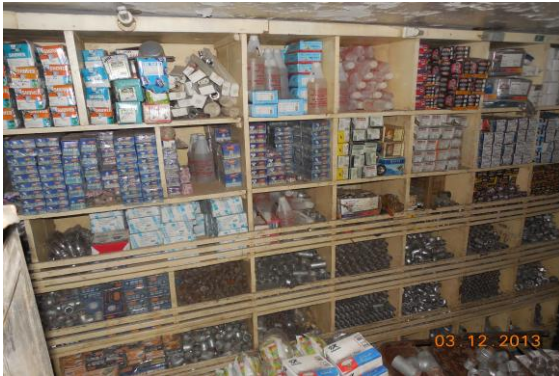
Photo 137

Wall No. 1 of Shop No. E 71, Basement Covered with Material

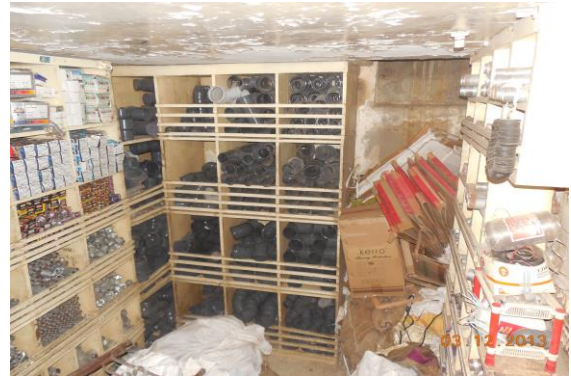
Photo 138

Wall No. 4 of Shop No. E 71, Basement Covered with Material

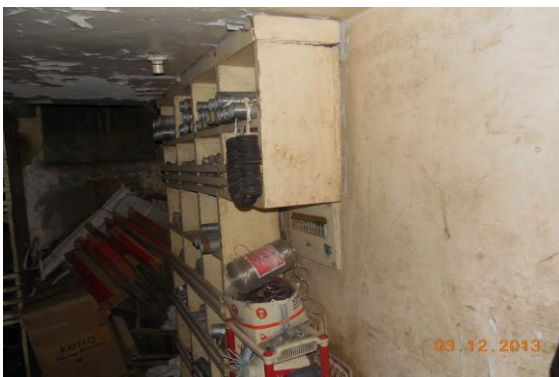
Photo 139

Wall No. 2 of Shop No. E 71, Basement Covered with Material

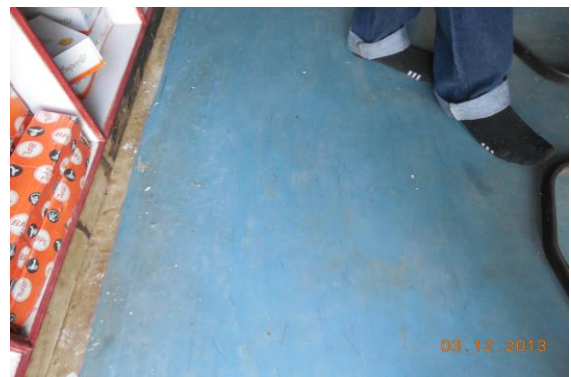
Photo 140

Floor of Shop No. E 71, Basement Covered with Material

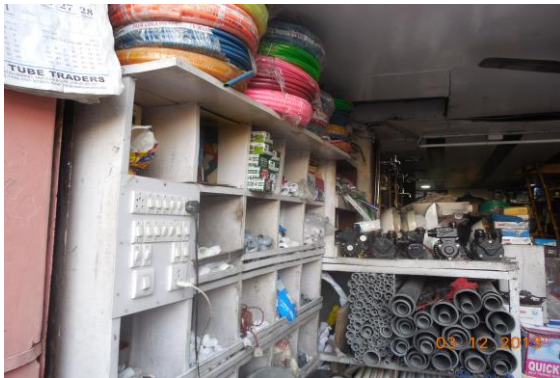
Photo 141

Wall No. 1 of Shop No. E 70 of Ground Floor Covered with Material

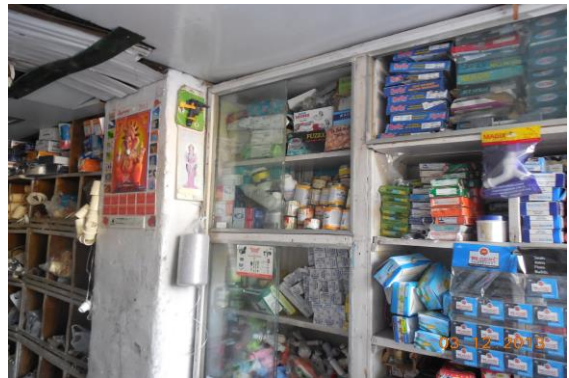
Photo 142

Wall No. 2 & 4 of Shop No. E 70 of Ground Floor Covered with Material

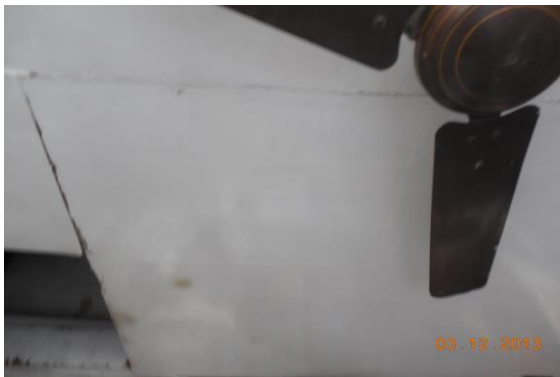
Photo 143

Roof of Shop No. E 70 of Ground Floor Covered with Material

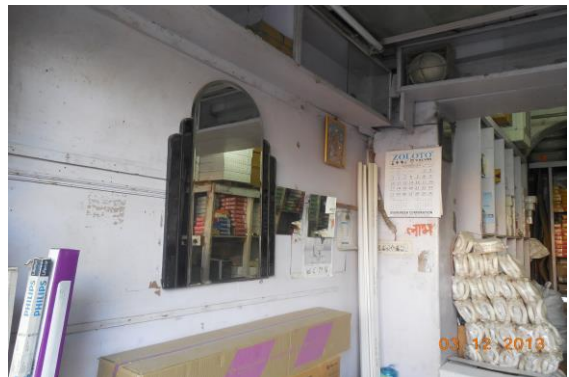
Photo 144

Wall No. 1 of Shop No. E 69 of Ground Floor Covered with Material

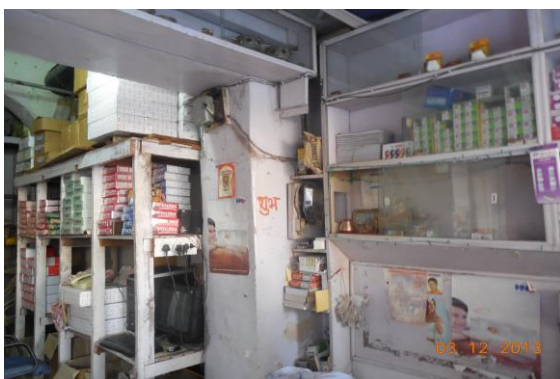
Photo 145

Wall No. 2 of Shop No. E 69 of Ground Floor Covered with Material

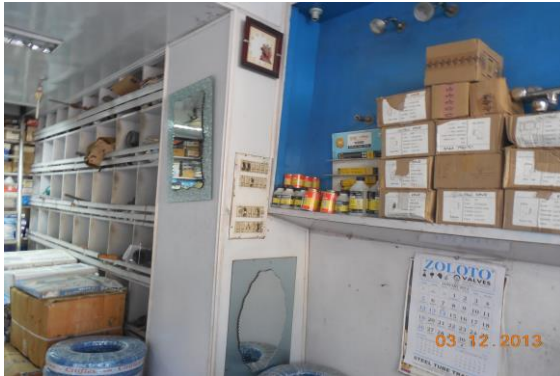
Photo 147

Wall No. 2 of Shop No. E 68 of Ground Floor Covered with Material

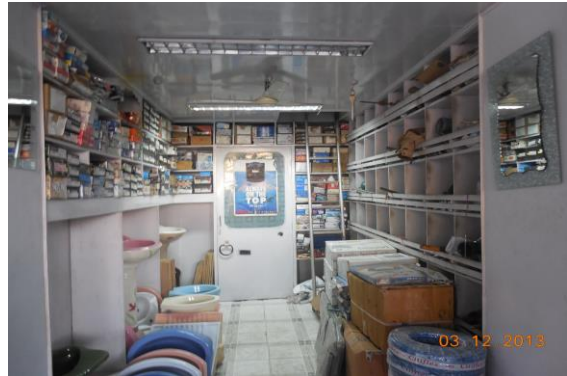
Photo 148

Wall No. 4 of Shop No. E 68 of Ground Floor Covered with Material

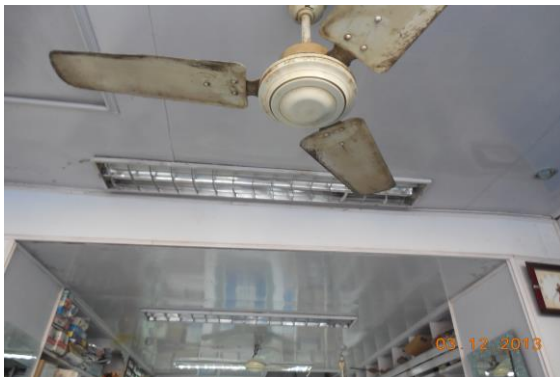
Photo 149

Roof of Shop No. E 68 of Ground Floor

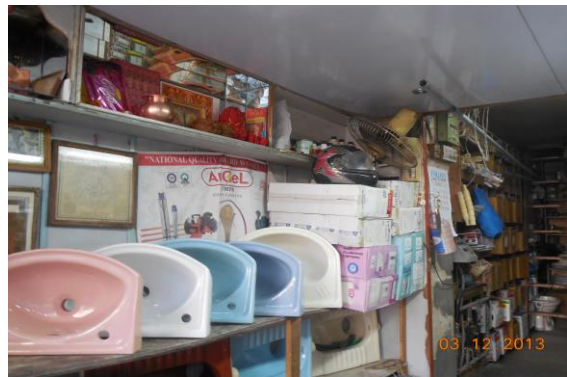
Photo 150

Wall No. 1 of Shop No. E 68 of Ground Floor Covered with Material

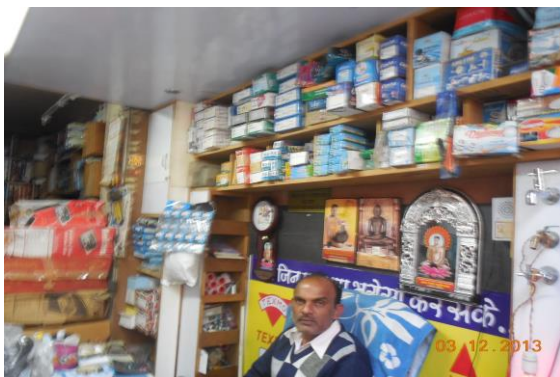
Photo 151

Wall No. 2 of Shop No. E 68 of Ground Floor Covered with Material

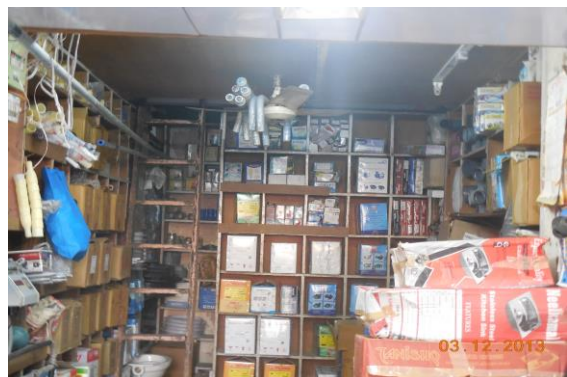
Photo 152

Wall No. 4 of Shop No. E 68 of Ground Floor Covered with Material

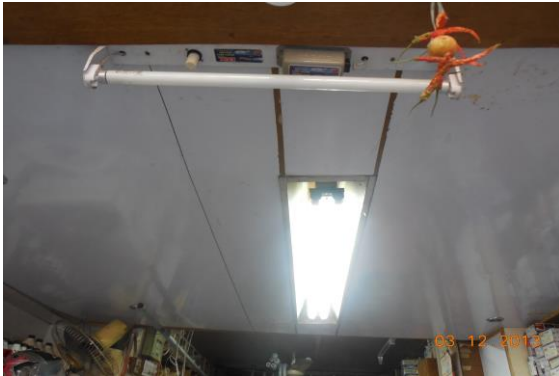
Photo 153
Roof of Shop No. E 68 of Ground Floor

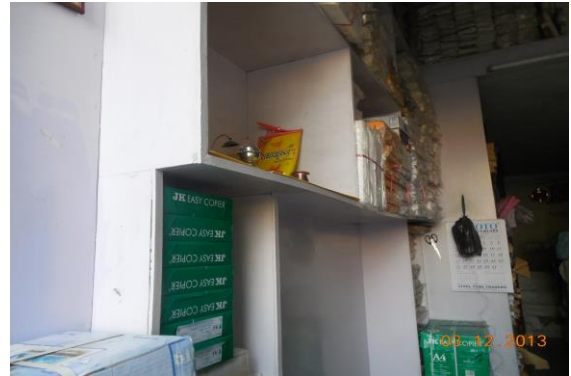
Photo 154
Wall No. 1 of Shop No. E 69 of Ground Floor Covered with Material

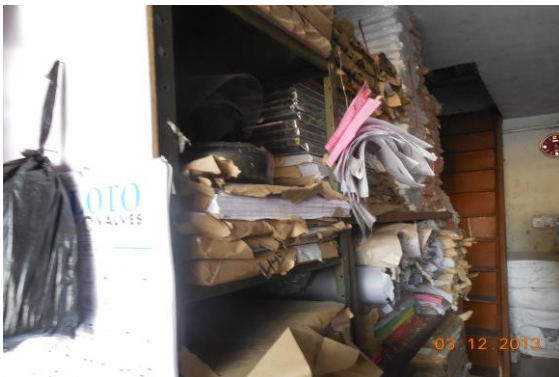
Photo 155
Wall No. 1 of Shop No. E 69 of Ground Floor Covered with Material

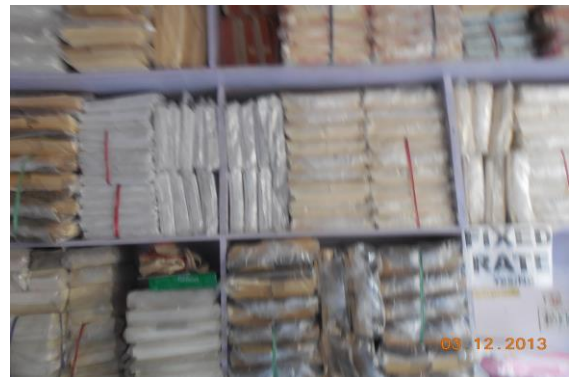
Photo 156
Wall No. 2 of Shop No. E 69 of Ground Floor Covered with Material

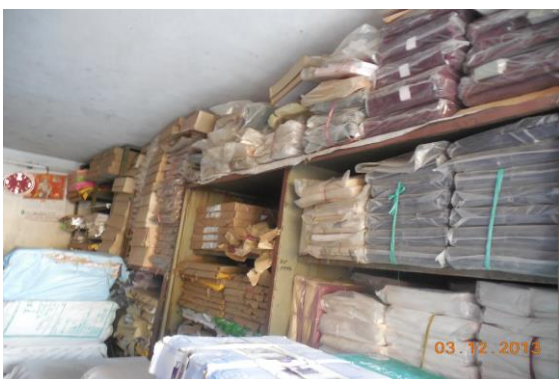
Photo 157
Wall No. 2 of Shop No. E 69 of Ground Floor Covered with Material

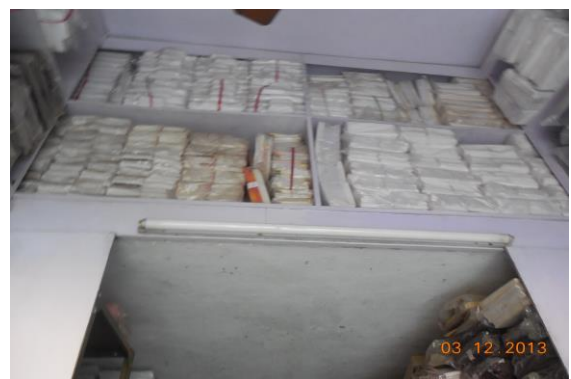
Photo 158
Wall No. 4 of Shop No. E 69, Upper Ground Floor Covered with Material

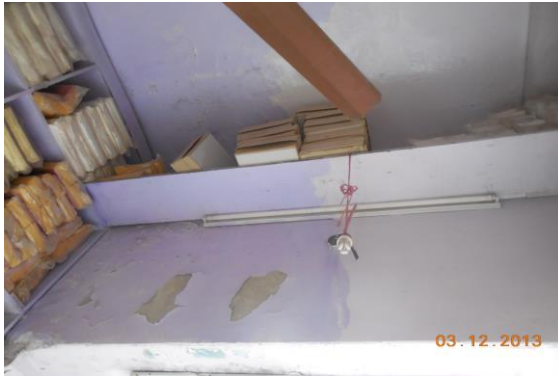
Photo 159

Wall No. 3 of Shop No. E 69, Upper Ground Floor Covered with Material

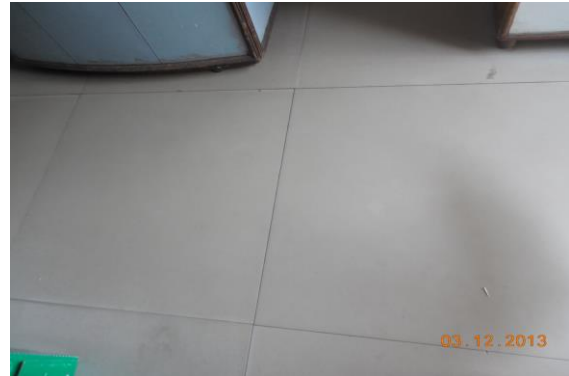
Photo 160

Floor of Shop No. E 69, Upper Ground Floor Covered with Tiles

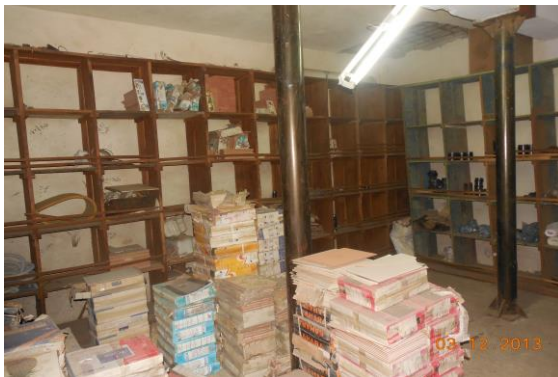
Photo 161

B2 of Shop No. E 64-65, Basement Covered with Material

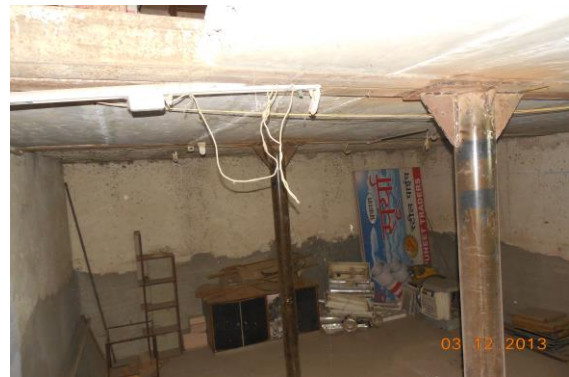
Photo 162

B1 of Shop No. E 64-65, Basement Covered with Tiles

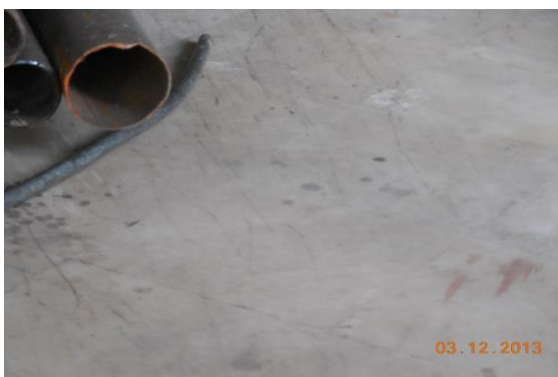
Photo 163

Floor Covered with Tiles

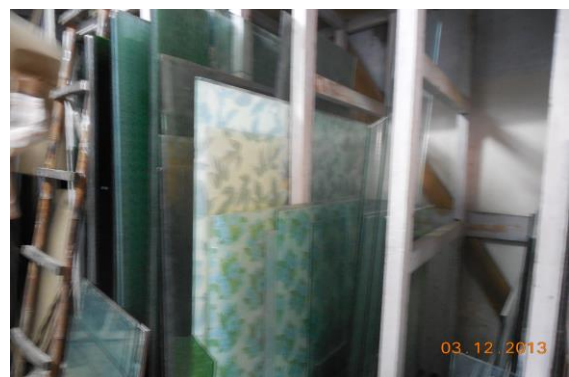
Photo 164

Wall No. 2 of Part C of Shop No. E 63, Ground Floor Covered with Material

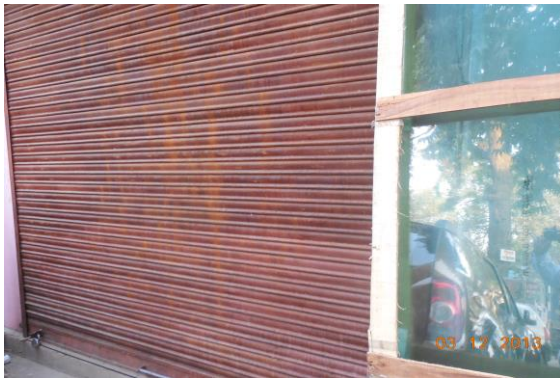
Photo 166
Wall No. 1 of Shop No. E 61 of Ground Floor Covered with Material

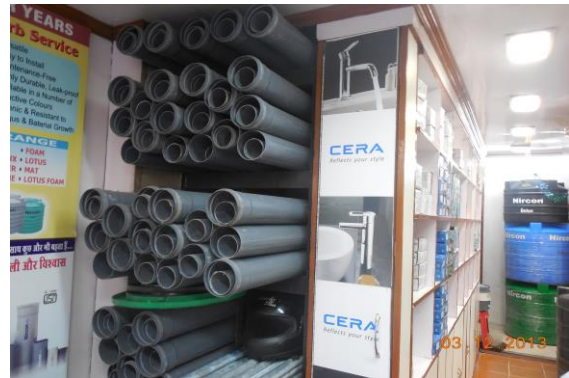
Photo 167
Wall No. 2 of Shop No. E 61 of Ground Floor Covered with Material

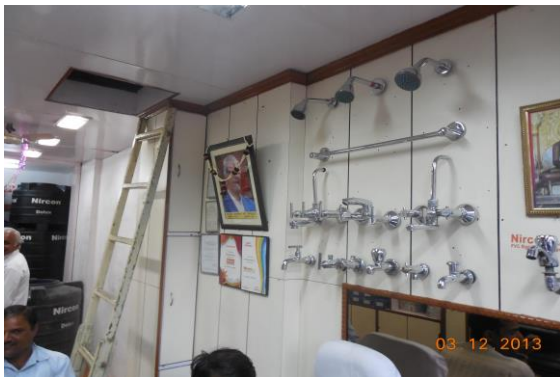
Photo 168
Roof of Shop No. E 61 of Ground Floor Covered with Wood Work

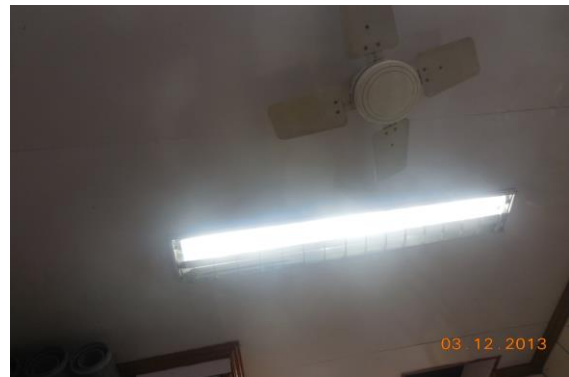
Photo 169
Wall No. 4 of Shop No. E 61 of Ground Floor Covered with Material

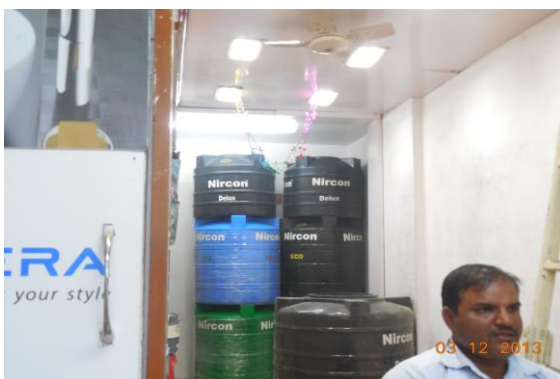
Photo 170
Wall No. 2 & 4 of Basement of Shop No. E 61, Basement Covered with Wood Work

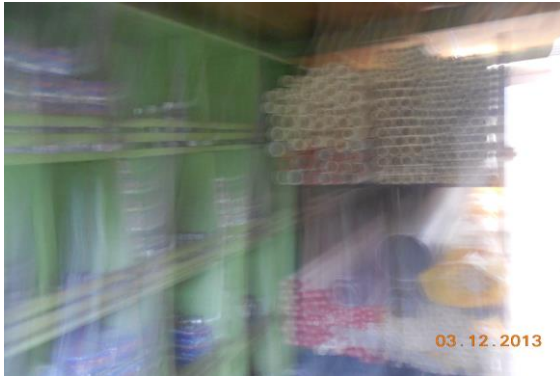
Photo 171

Wall No. 3 of Basement of Shop No. E 61, Basement Covered with Material

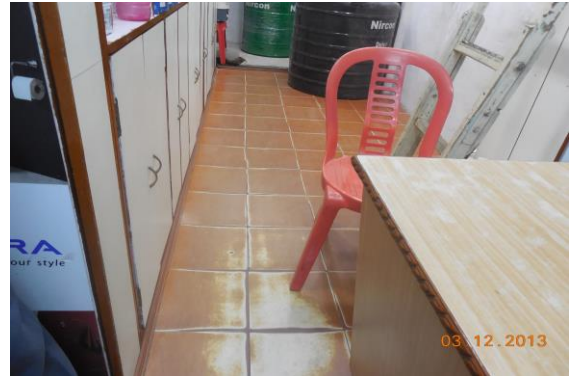
Photo 172

Floor of Shop No. E 61 of Ground Floor Covered with Tiles

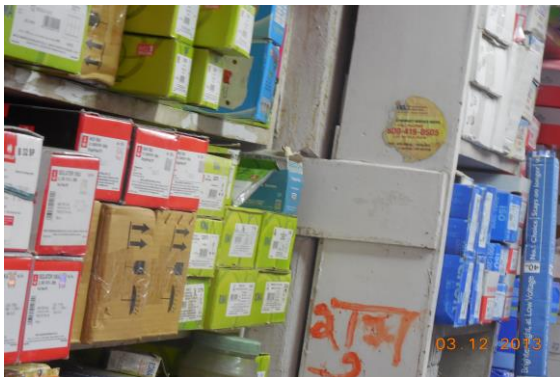
Photo 173

Wall No. 1 of Shop No. E 60 of Ground Floor Covered with Material

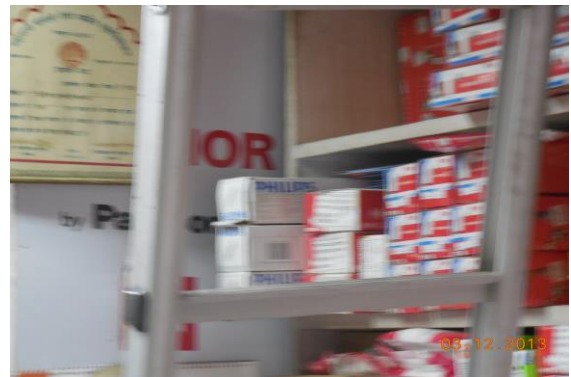
Photo 174

Wall No. 2 of Shop No. E 60 of Ground Floor Covered with Material

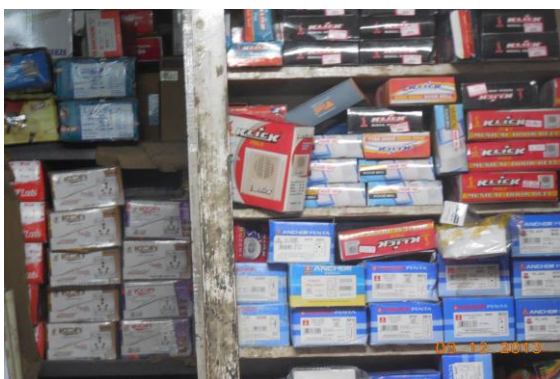
Photo 175

Wall No. 4 of Shop No. E 60 of Ground Floor Covered with Material

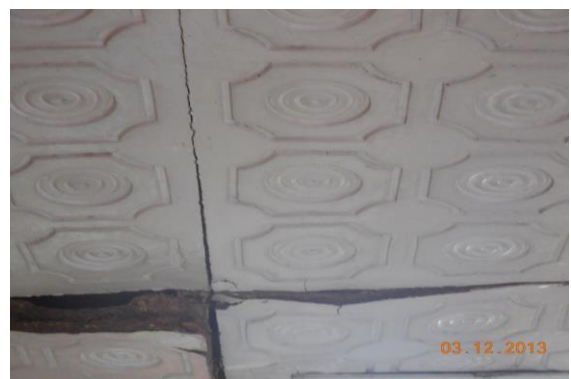
Photo 176

Shop No. E 60 of Ground Floor Covered with Material

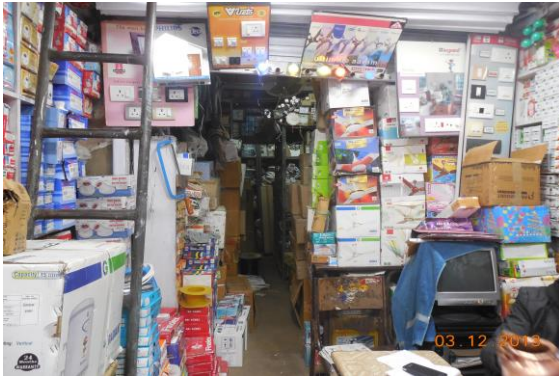
Photo 177

Wall No. 1, 2 & 4 of Shop No. E 59 of Ground Floor Covered with Material

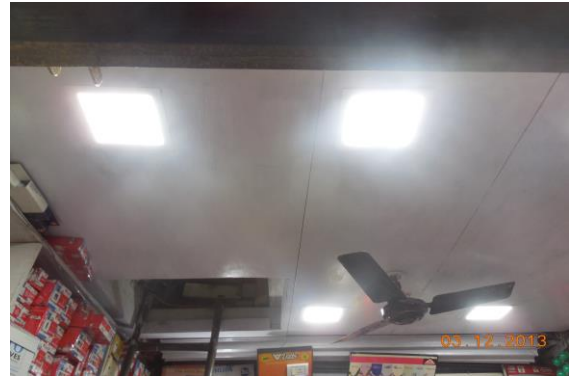
Photo 178

Roof of Shop No. E 59 of Ground Floor Covered with Wood Work

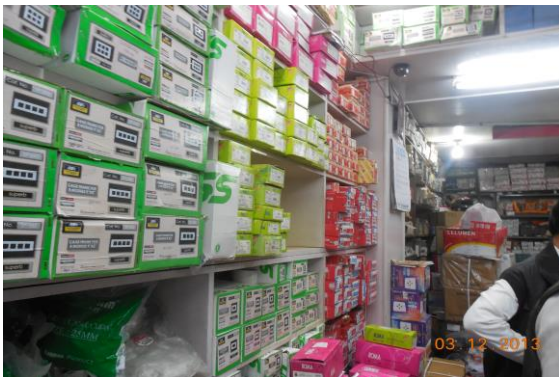
Photo 179

Wall No. 1 of Part A of Shop No. E 58, Ground Floor Covered with Material

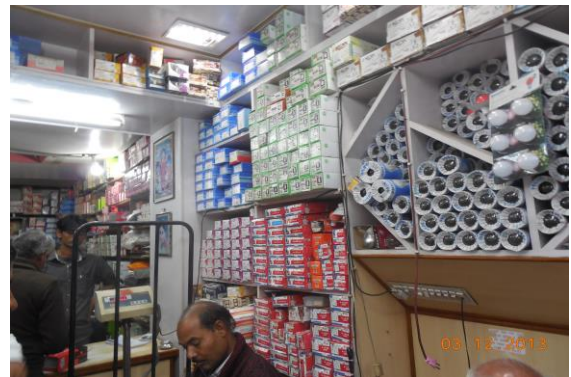
Photo 180

Wall No. 2 of Shop No. E 58 of Ground Floor Covered with Material

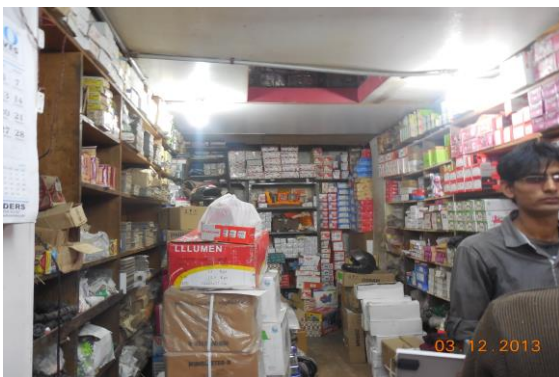
Photo 181

Wall No. 4 of Shop No. E 58 of Ground Floor Covered with Material

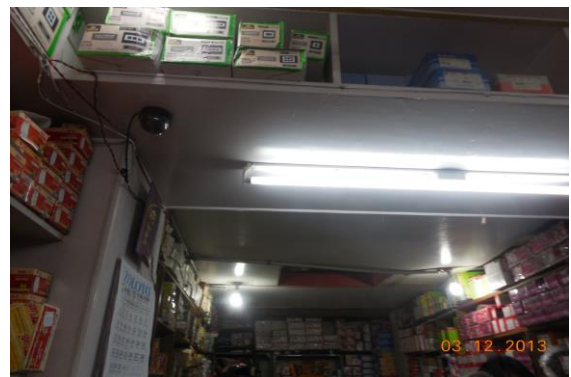
Photo 182

Roof of Part A of Shop No. E 58, Ground Floor Covered with Wood Work

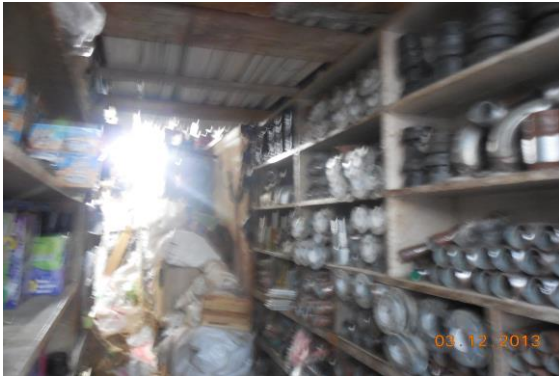
Photo 183

All Walls of Part B of Shop No. E 58, Ground Floor Covered with Material

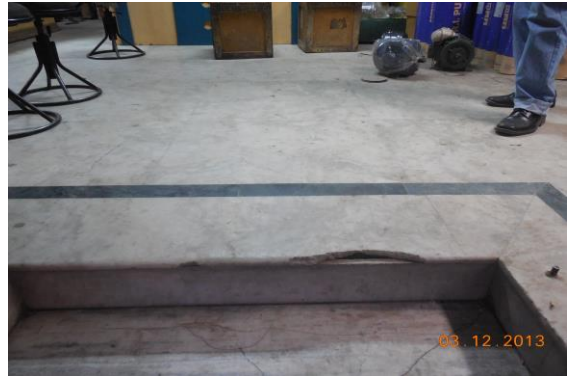
Photo 184

Floor of Shop No. E 144 of Ground Floor Covered with Tiles

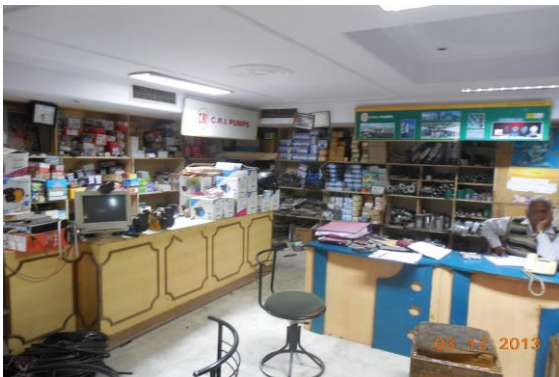
Photo 185

Wall No. 1 & 4 of Shop No. E 144 of Ground Floor Covered with Material

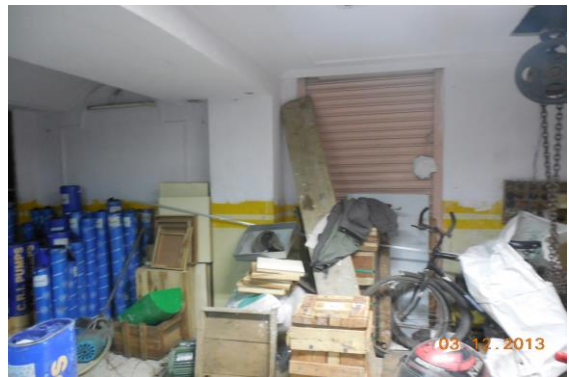
Photo 186

Wall No. 2 of Shop No. E 144 of Ground Floor Covered with Material

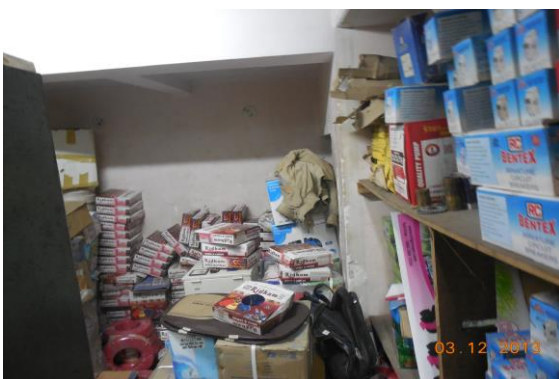
Photo 187

Cabin of Shop No. E 144, Ground Floor Covered with Glass

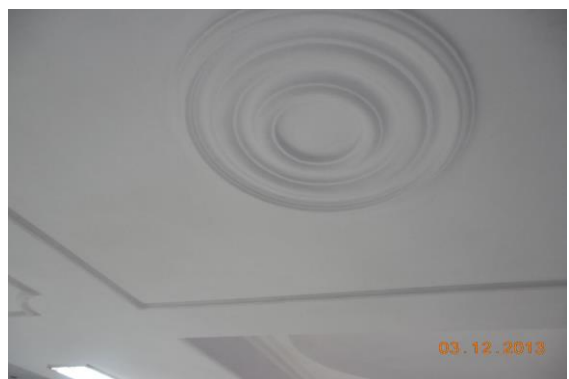
Photo 188

Roof of Shop No. E 144 of Ground Floor Covered with Wood Work

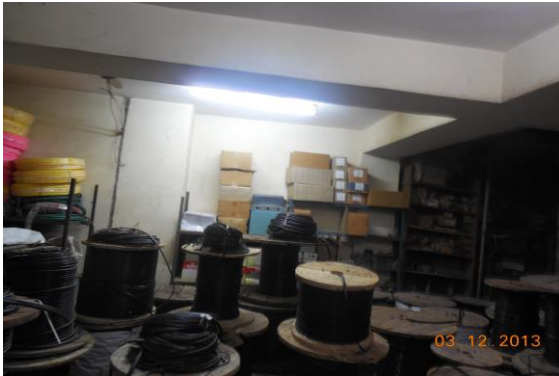
Photo 189

Wall No. 2 of Shop No. E 144, Basement Covered with Material

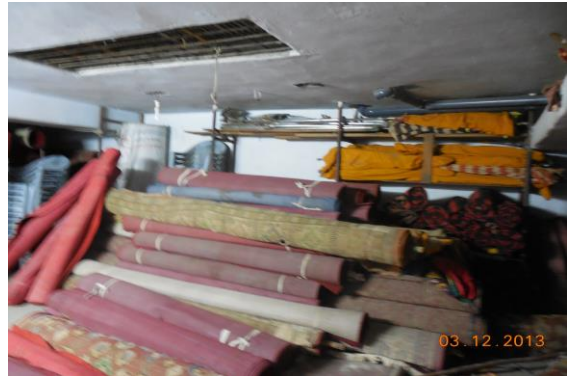
Photo 190

Wall No. 1 & 4 of Shop No. D 54, Basement 1 Covered with Material

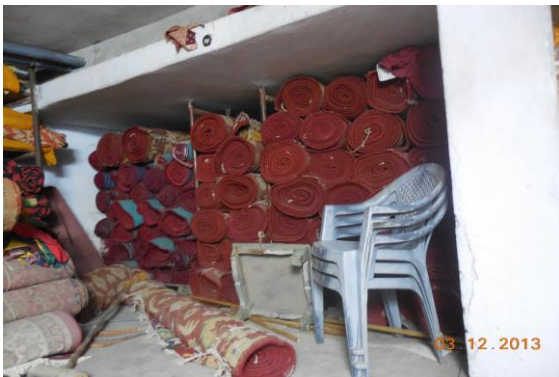
Photo 191

Wall No. 2 of Shop No. D 54, Basement 1 Covered with Material

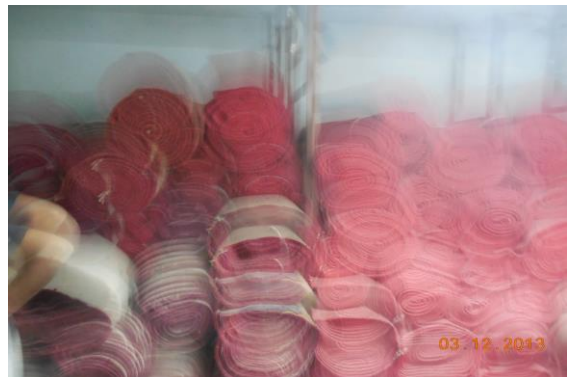
Photo 192

Wall No. 4 of Shop No. D 54, Basement 2 Covered with Material

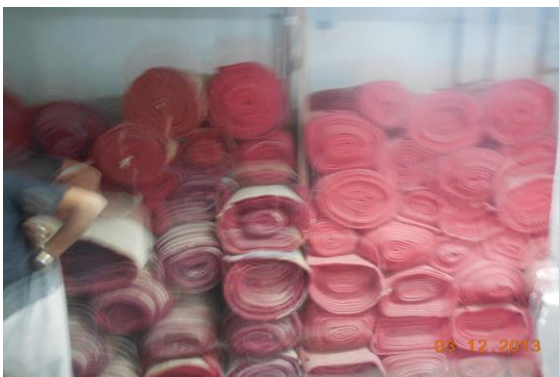
Photo 193

Wall No. 4 of Shop No. D 54, Basement 2 Covered with Material

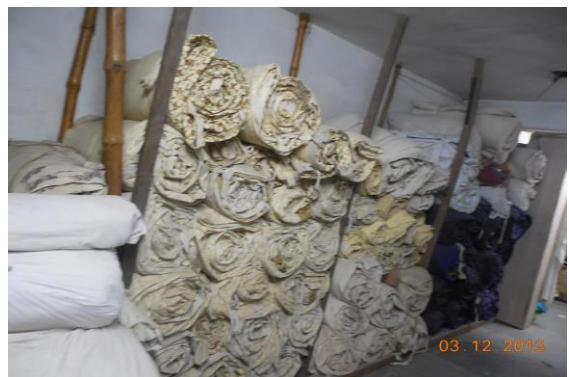
Photo 194

Wall No. 2 of Shop No. D 54, Basement 2 Covered with Material

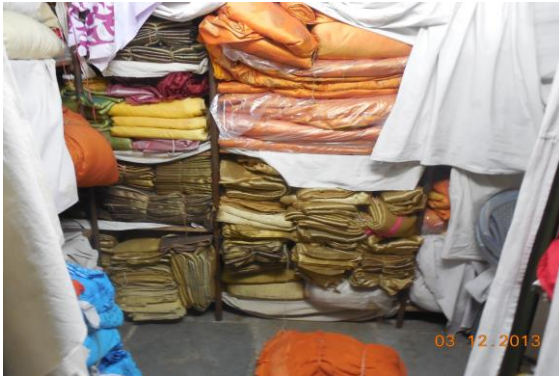
Photo 195

Wall No. 3 of Shop No. D 54, Basement 2 Covered with Material

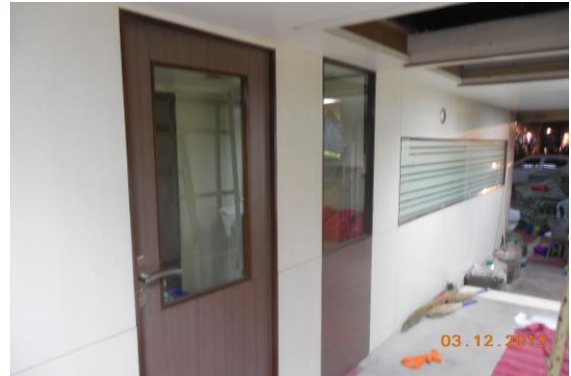
Photo 196

Shop No. D 54 of Ground Floor Covered with Wood Work

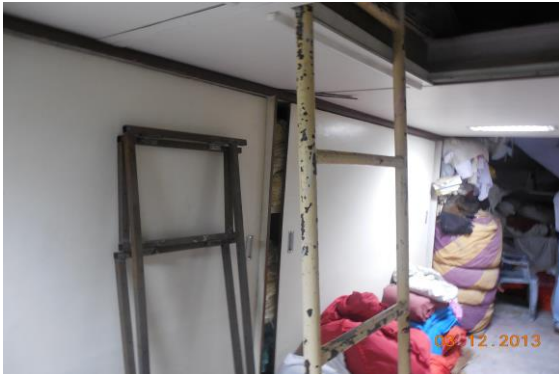
Photo 197

Wall No. 1 of Shop No. D 54 of Ground Floor Covered with Material

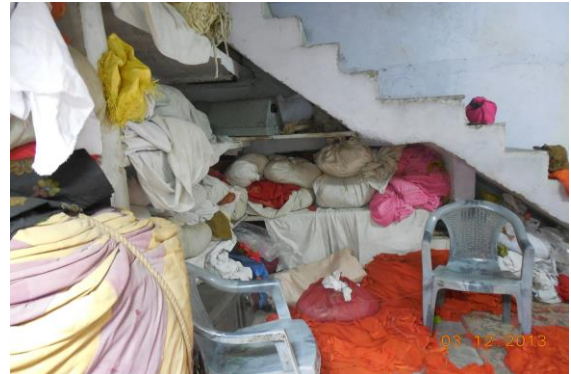
Photo 198

Wall No. 4 of GF, Part A of Shop No. D 54, Ground Floor Covered with Material

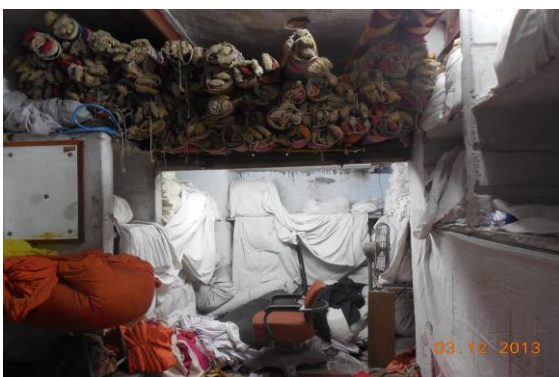
Photo 199

Wall No. 4 of Part B of Shop No. D 54, Ground Floor Covered with Material

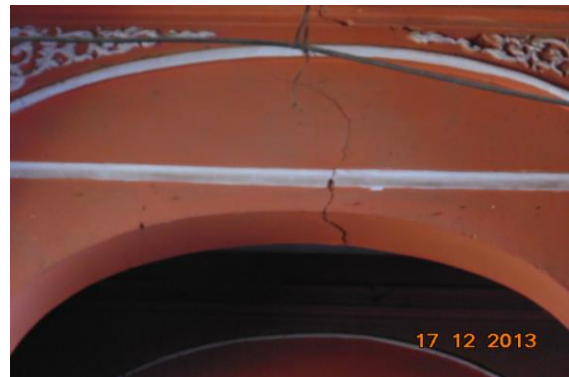
There are 39 defects in the structure out of which 1 are cracks. Category wise distribution of cracks is given in the table below. Overall the Building can be categorised in Category II (Slight)

Photo 4
Inclined Crack on Wall No. 1 of Passage, Historical Gate No.2, Ground Floor Approx. Width = 1.5mm, Approx. Length = 0.8m. Distance from Wall No.3 = 5m, Height from Floor = 3.5m.

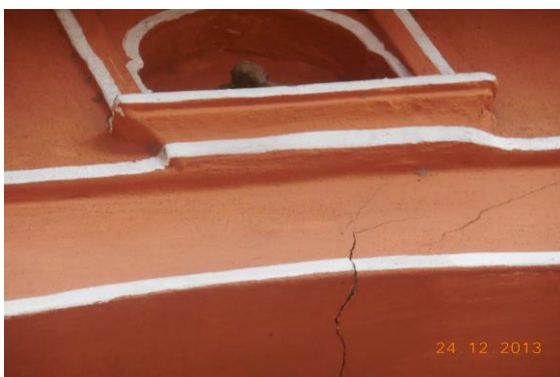
Photo 5
Peeling of Plaster on Wall No. Gate of Gate No.1 of Ground Floor

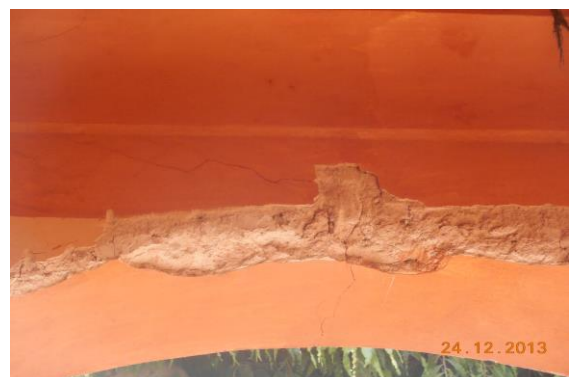
Photo 6
Peeling of Plaster on Roof of Gate No.1 of Ground Floor

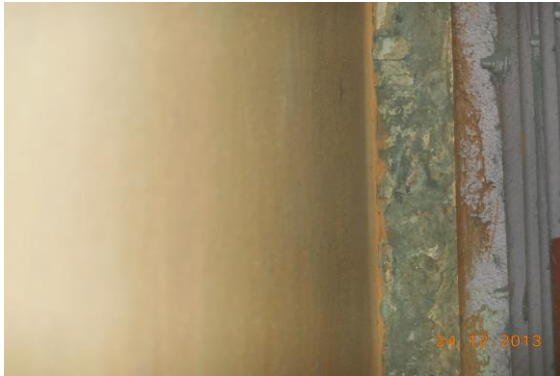
Photo 7

Peeling of Plaster on Wall No. 2 of Gate No.1 of Ground Floor

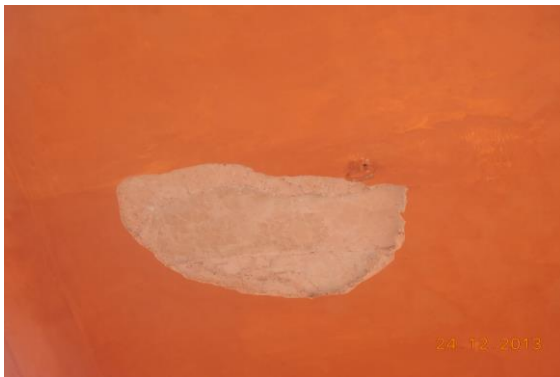
Photo 9

Peeling of Plaster on Roof of Gate No.1 of Ground Floor

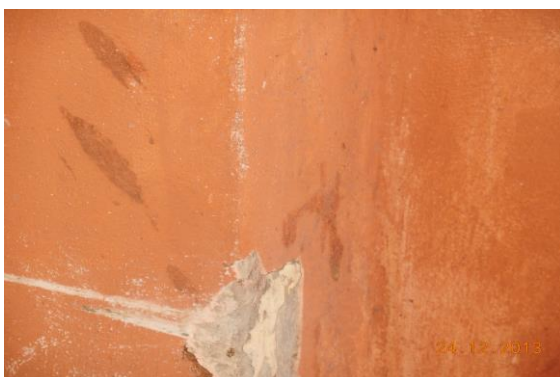
Photo 11

Peeling of Plaster on Wall No. 1 of Gate No.1 of Ground Floor

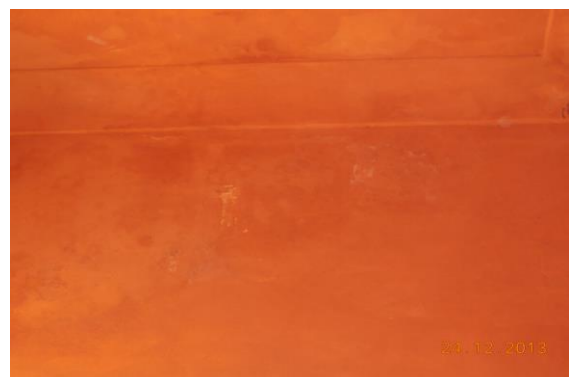
Photo 12

Dampness/Seepage on Wall No. 1 of Gate No.1 of Ground Floor

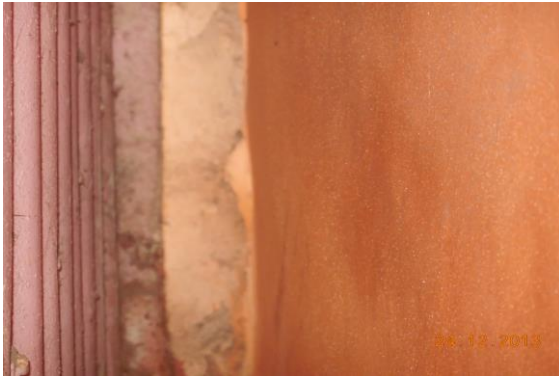
Photo 13
Damaged Portion on Wall No. 1 of Gate No.1 of Ground Floor

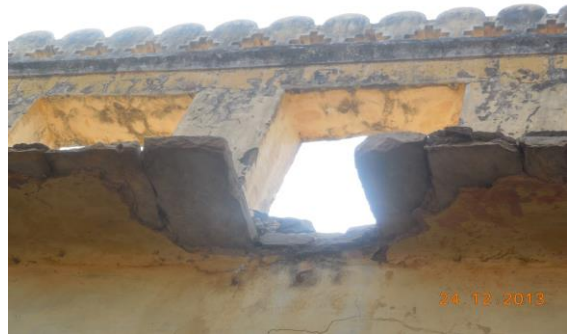
Photo 14
Peeling of Plaster on Roof Shed of Gate No.1 of Ground Floor

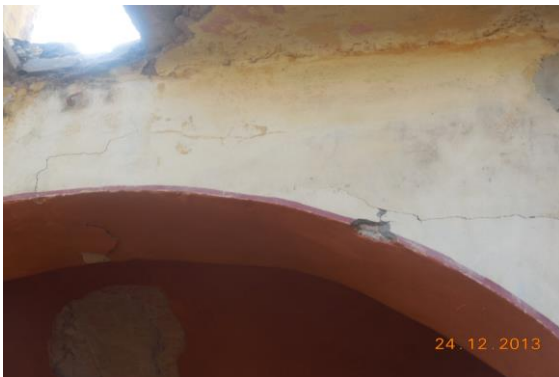
Photo 15
Peeling of Plaster on Backside of Gate No.1 of Ground Floor

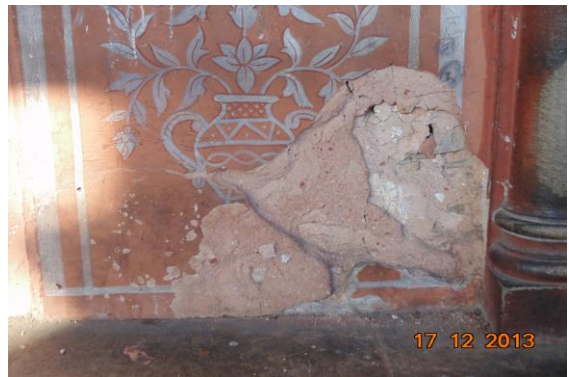
Photo 16
Damaged Portion on Wall No. 4 of Left Tomb of Ground Floor

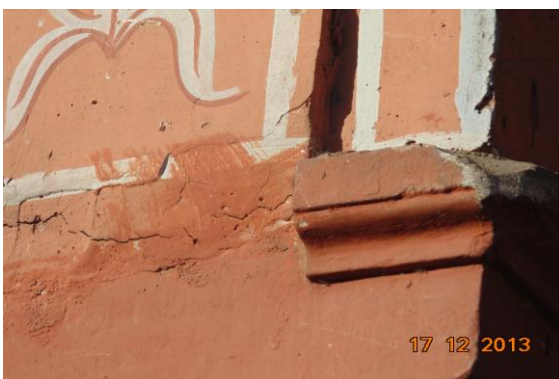
Photo 17
Damaged Portion on Wall No. 4 of Historical Gate No.2 of Ground Floor

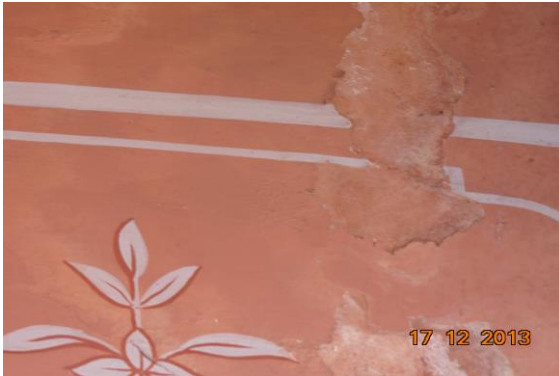
Photo 19

Peeling of Plaster on Wall No. 4 of Historical Gate No.2 of Ground Floor

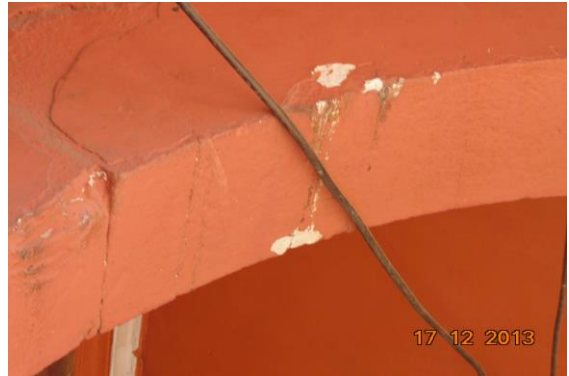
Photo 20

Peeling of Plaster on Roof of Passage of Historical Gate No.2, Ground Floor

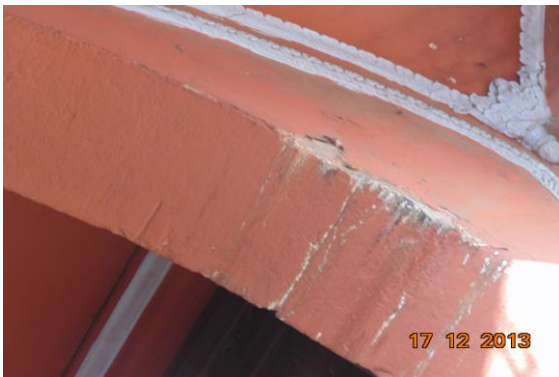
Photo 21

Peeling of Plaster on Roof of Passage of Historical Gate No.2, Ground Floor

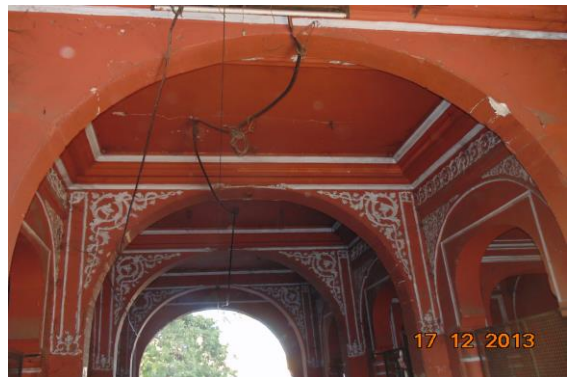
Photo 22

Peeling of Plaster on Roof of Passage of Historical Gate No.2, Ground Floor

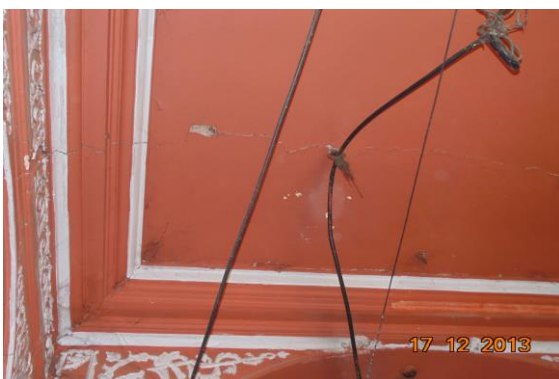
Photo 23

Damaged Portion on Roof of Passage of Historical Gate No.2, Ground Floor

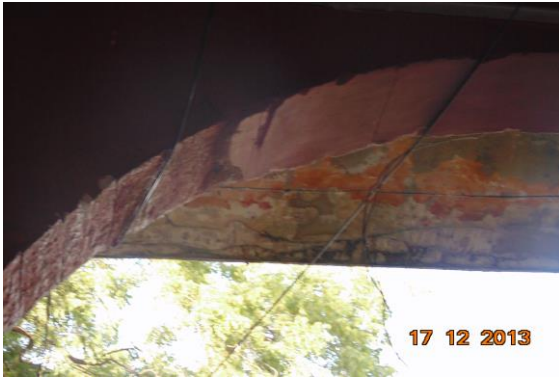
Photo 25

Damaged Portion on Roof of Passage of Historical Gate No.2, Ground Floor

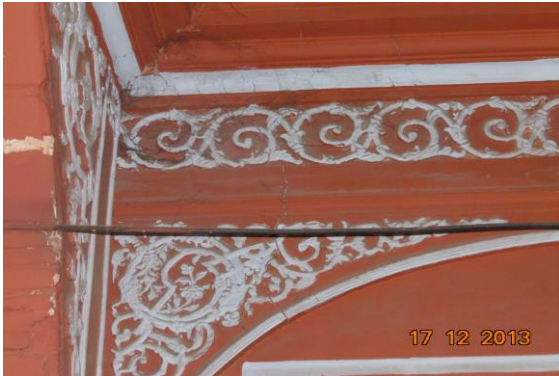
Photo 27

Damaged Portion on Wall No. 1 of Passage of Historical Gate No.2, Ground Floor

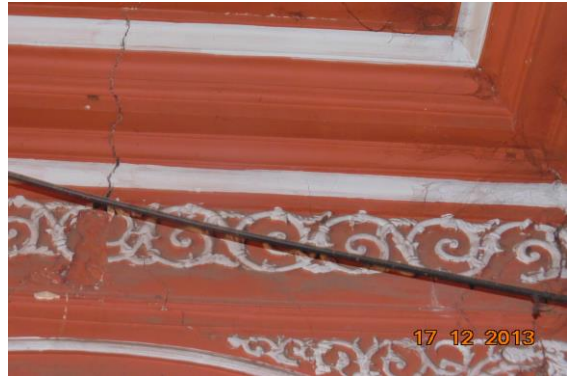
Photo 28

Damaged Portion on Wall No. 1 of Passage of Historical Gate No.2, Ground Floor

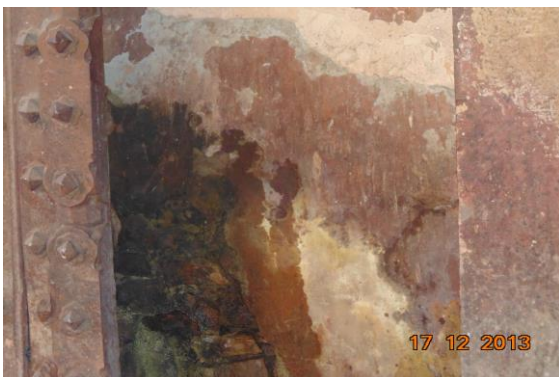
Photo 29

Damaged Portion on Wall No. 1 of Passage of Historical Gate No.2, Ground Floor

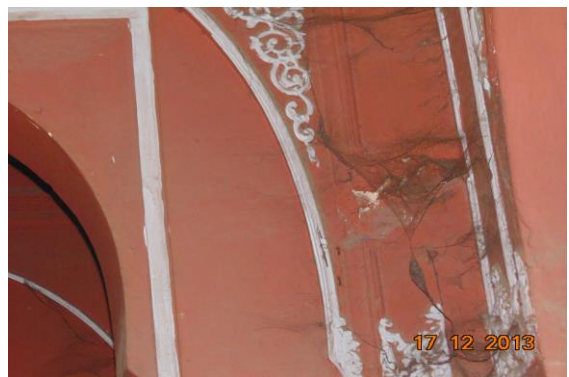
Photo 30

Damaged Portion on Wall No. 1 of Passage of Historical Gate No.2, Ground Floor

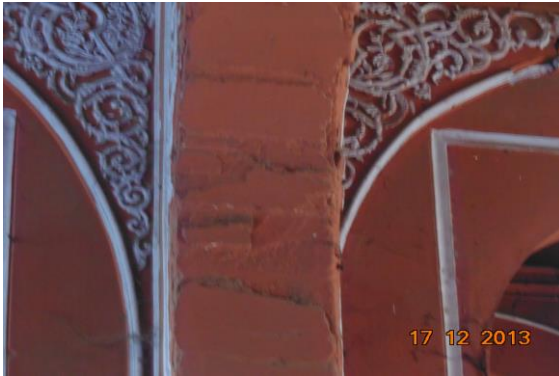
Photo 31

Peeling of Plaster on Wall No. 2 of Passage of Historical Gate No.2,
Ground Floor

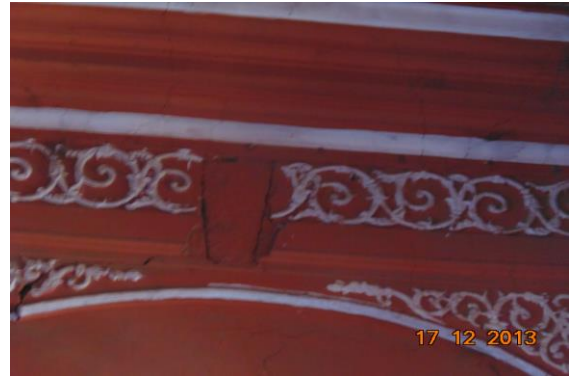
Photo 32

Peeling of Plaster on Wall No. 2 of Passage of Historical Gate No.2,
Ground Floor

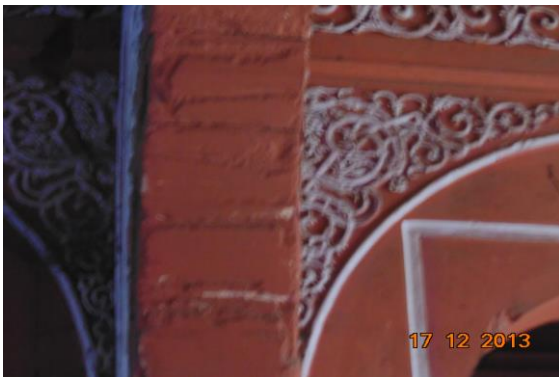
Photo 33

Peeling of Plaster on Wall No. 2 of Passage of Historical Gate No.2,
Ground Floor

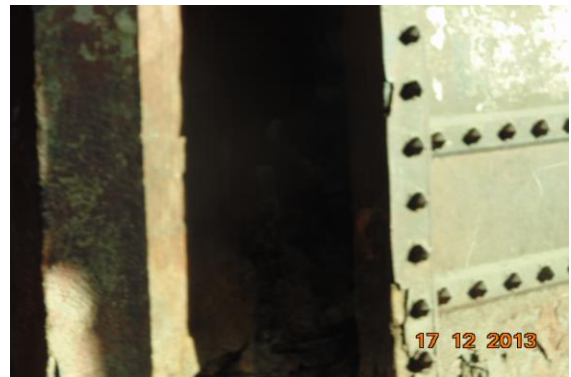
Photo 34

Damaged Portion on Wall No. 2 of Passage of Historical Gate No.2,
Ground Floor

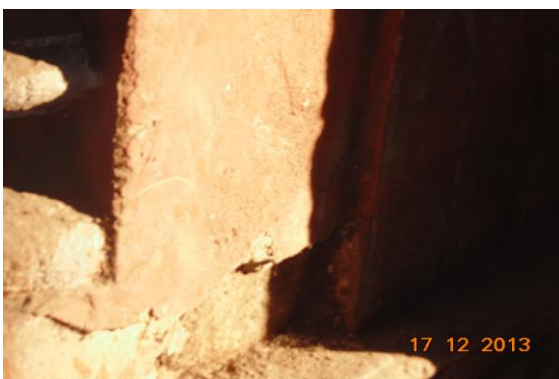
Photo 35

Damaged Portion on Wall No. 2 of Passage of Historical Gate No.2,
Ground Floor

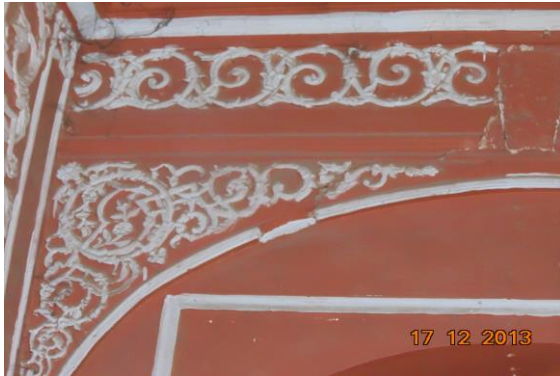
Photo 37

Damaged Portion on Wall No. 2 of Passage of Historical Gate No.2, Ground Floor

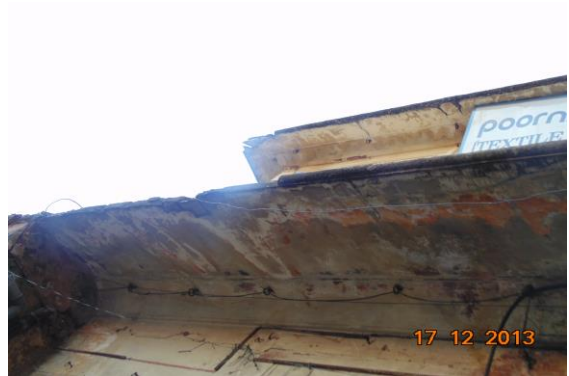
Photo 38

Damaged Portion on of Historical Gate No.2 of Ground Floor

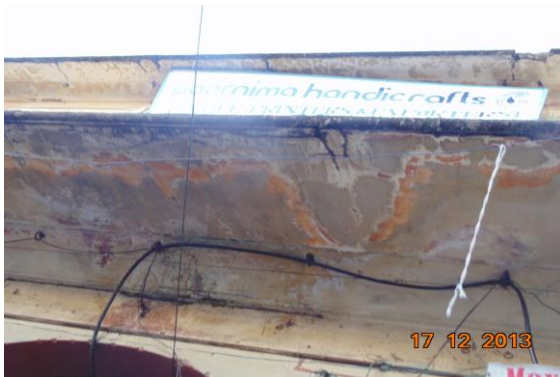
Photo 39

Dampness/Seepage on of Historical Gate No.2 of Ground Floor

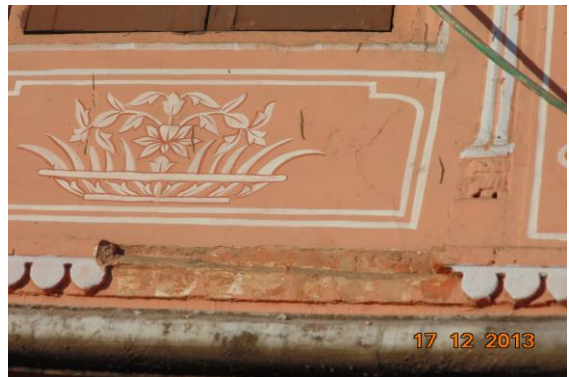
Photo 40

Peeling of Plaster on Backside Wall of Poornima Handicrafts of Historical Gate No.2, Ground Floor

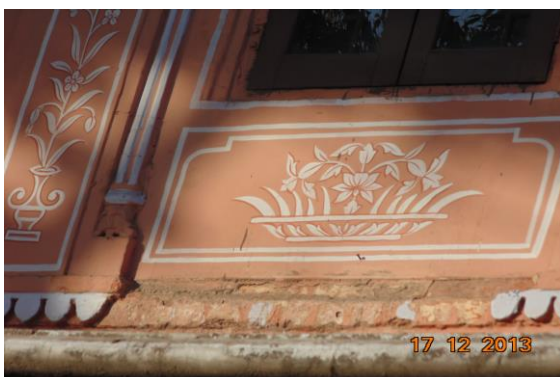
Photo 41

Peeling of Plaster on Backside Wall of Poornima Handicrafts of Historical Gate No.2, Ground Floor

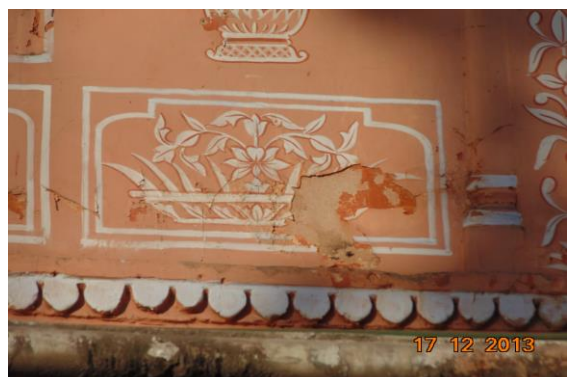
Photo 42

Peeling of Plaster on Backside Wall of Poornima Handicrafts of Historical Gate No.2, Ground Floor
