Pre Building Condition Survey Report

Name and Address of Structure :	Choti Chopar to Badi Chopar (UP Line)
---------------------------------	---------------------------------------

Name of the Project	Contract JMRC-UG1B “Design and Construction of Tunnel between Chandpole and Badi Chouper and reverse line by Shield TBM, Underground Metro Stations at Choti Chouper and Badi Chouper by Cut and Cover Methods on East West Corridor of Jaipur Metro Rail Corporation Limited .”	
Owner :

Shoping Complex - Shop No. 169-188
Tripolia Bazar
Jaipur
Unique ID: CC BC UP 0001

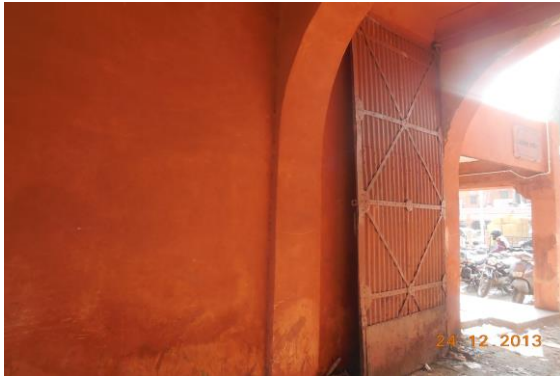
Photo 43
Gate No.1 of Ground Floor Covered With Gate

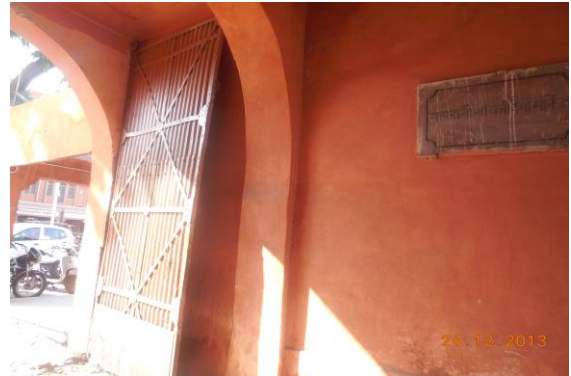
Photo 44
Gate No.1 of Ground Floor Covered With Gate

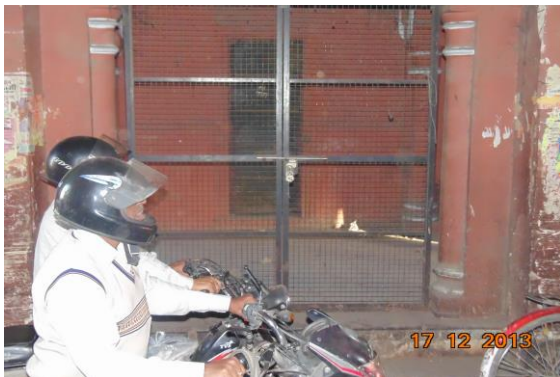
Photo 45
Varanda No.2 of Historical Gate No.2, Ground Floor Locked

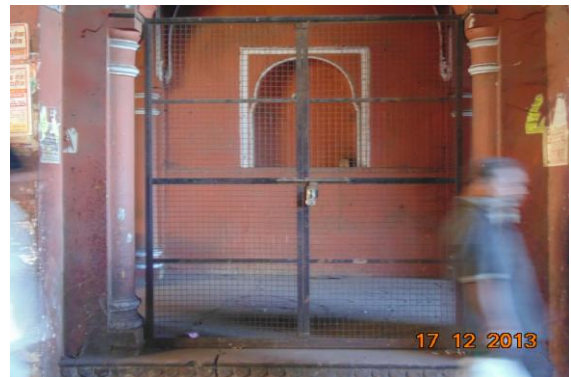
Photo 46
Varanda No.1 of Historical Gate No.2, Ground Floor Locked

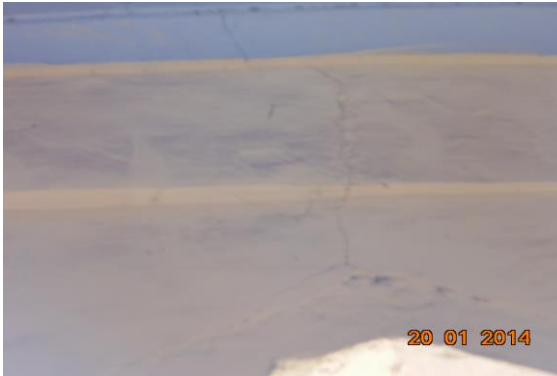
Photo 7

Inclined Crack on Wall No. 3 & Roof of First Face, Ground Floor, Tripoliya Gate, Approx. Width = 0.4mm, Approx. Length = 2m. Distance from Wall 2 = 2m, Height from Floor = 8.5m.

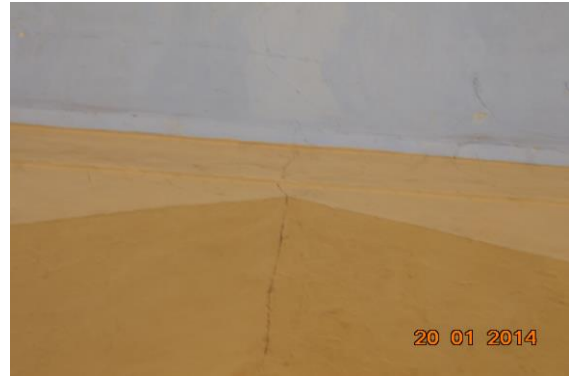
Photo 8

Inclined Crack on Wall No. 4 & Roof of First Face, Ground Floor, Tripoliya Gate, Approx. Width = 0.6mm, Approx. Length = 2.5m. Distance from Wall 2 = 2m, Height from Floor = 8.5m.

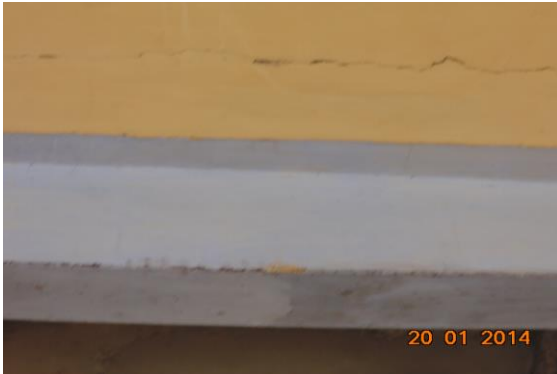
Photo 9

Horizontal Crack on Roof of Second Face, Ground Floor, Tripoliya Gate, Approx. Width = 1mm, Approx. Length = 2.5m. Distance from wall 1 = 0m, Height from Floor = 8.5m.

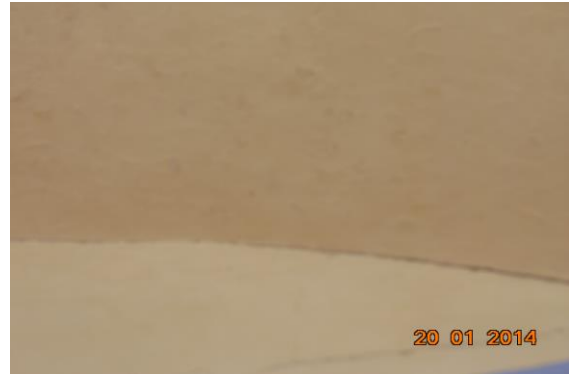
Photo 10

Horizontal Crack on Wall No. 4, First Face & Roof, Second Face of Ist Face to Iind Face Roof, Ground Floor, Tripoliya Gate Approx. Width = 3mm, Approx. Length = 2m.

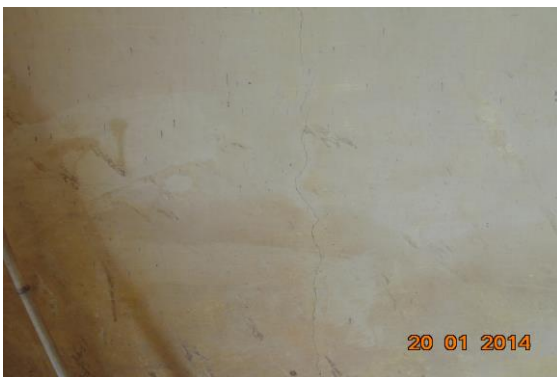
Photo 11

Inclined Crack on of Space 1, Third Face, Ground Floor, Tripoliya Gate, Approx. Width = 0.6mm, Approx. Length = 2.5m. Distance from Wall 4 = 2m, Height from Floor = 0m.

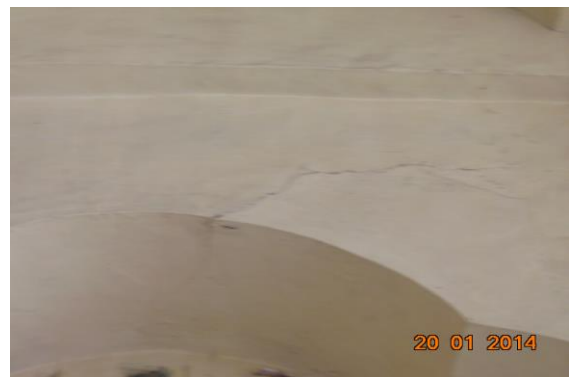
Photo 12

Inclined Crack on of Space 4, Third Face, Ground Floor, Tripoliya Gate, Approx. Width = 1mm, Approx. Length = 1m. Distance from Wall 3 = 1.5m, Height from Floor = 3m.

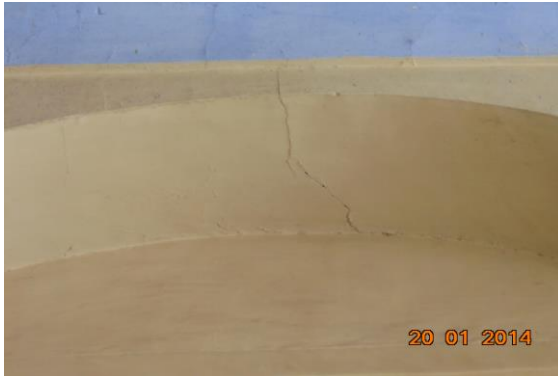
Photo 13

Inclined Crack on Roof of Third Face, Ground Floor, Tripoliya Gate, Approx. Width = 1mm, Approx. Length = 0.6m. Distance from Wall 3 = 1.8m, Height from Floor = 4m.

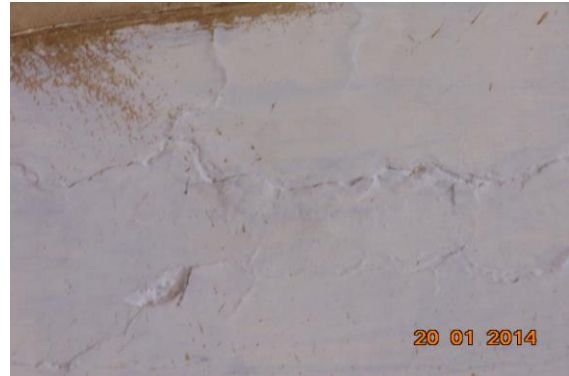
Photo 14

Horizontal Crack on Roof of Third Face, Ground Floor, Tripoliya Gate, Approx. Width = 1mm, Approx. Length = 2.5m. Distance from Wall 4 = 0m, Height from Floor = 8.5m.

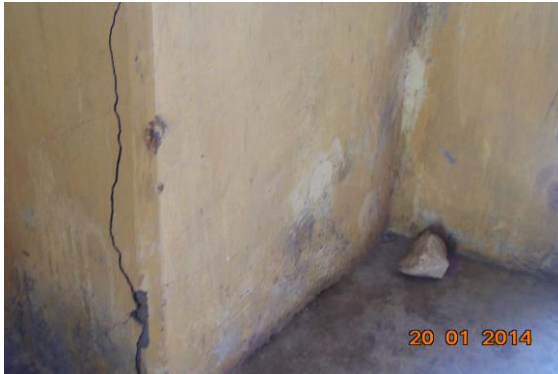
Photo 15

Vertical Crack on Wall No. 2 of Space 4, Third Face, Ground Floor, Tripoliya Gate, Approx. Width = 1mm, Approx. Length = 0.6m. Distance from Wall 4 = 0.4m, Height from Floor = 0m.

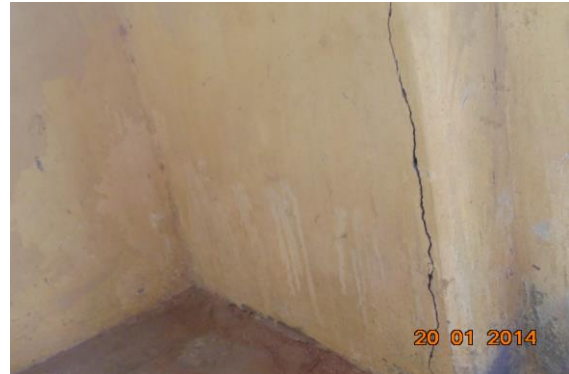
Photo 16

Vertical Crack on Wall No. 2 of Space 4, Third Face, Ground Floor, Tripoliya Gate, Approx. Width = 1mm, Approx. Length = 0.6m. Distance from Wall 4 = 0.5m, Height from Floor = 0m.

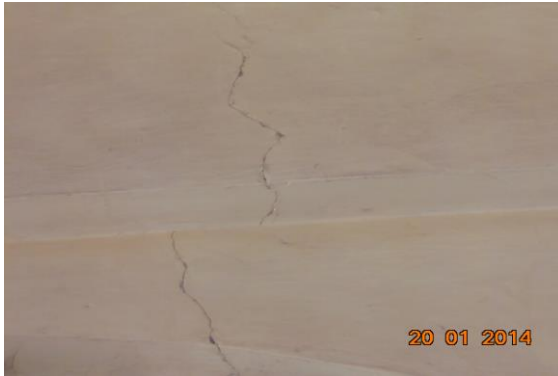
Photo 19

Inclined Crack on Wall No. 4 of Space 2, Forth Face, Ground Floor, Tripoliya Gate, Approx. Width = 1mm, Approx. Length = 1m. Distance from Wall 4 = 1.2m, Height from Floor = 3.2m.

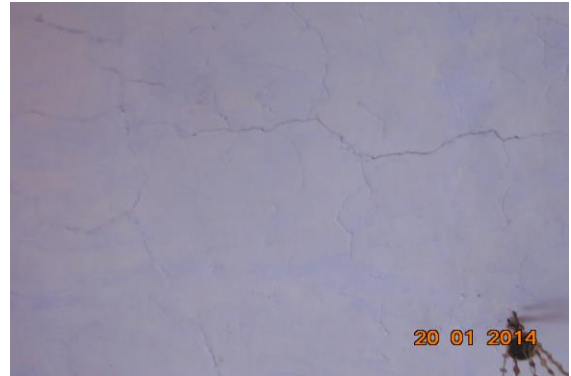
Photo 20

Inclined Crack on Roof of Fifth Face, Ground Floor, Tripoliya Gate, Approx. Width = 1.5mm, Approx. Length = 3.2m. Distance from Space 2 = 2m, Height from Floor = 8.5m.

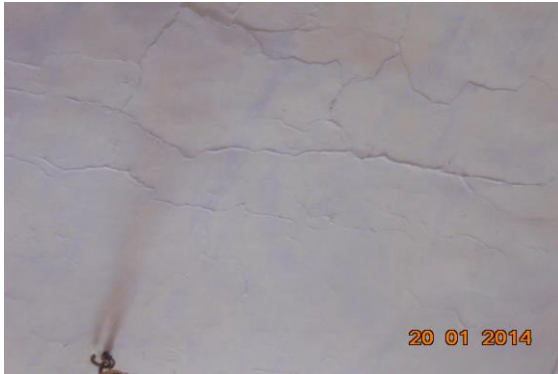
Photo 21

Horizontal Crack on Roof of Fifth Face, Ground Floor, Tripoliya Gate, Approx. Width = 0.6mm, Approx. Length = 3.2m. Distance from Space 2 = 10m, Height from Floor = 8.5m.

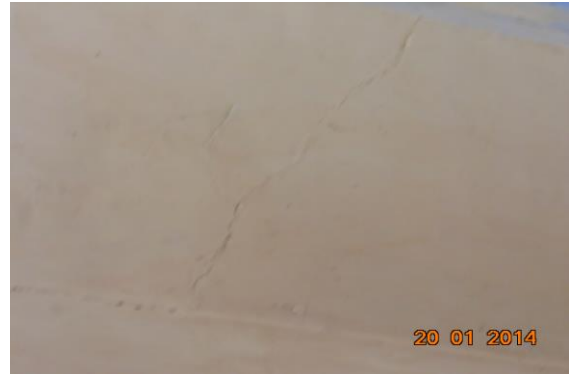
Photo 22

Horizontal Crack on Roof of Space 5, Fifth Face, Ground Floor, Tripoliya Gate, Approx. Width = 0.4mm, Approx. Length = 0.4m. Distance from Wall 2 = 2m, Height from Floor = 8.5m.

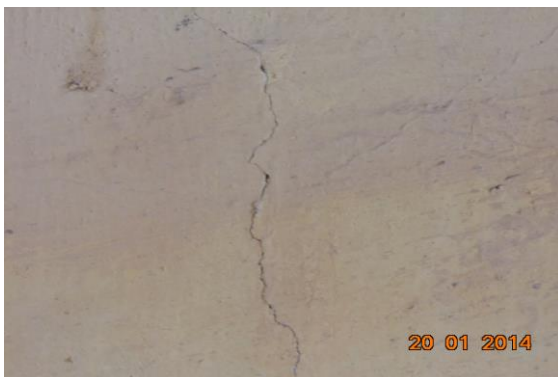
Photo 23

Inclined Crack on Wall No. 4 of Space 5, Fifth Face, Ground Floor, Tripoliya Gate, Approx. Width = 0.6mm, Approx. Length = 0.5m. Distance from Wall 1 = 1.2m, Height from Floor = 0m.

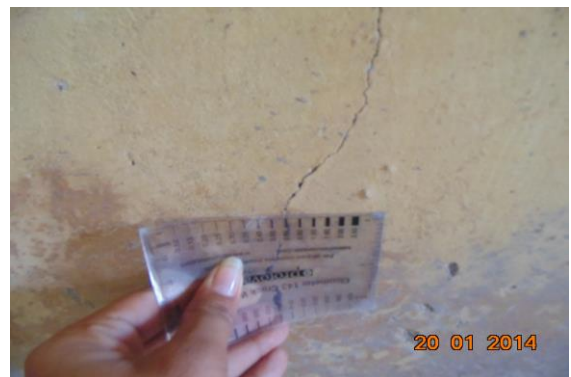
Photo 23A

Inclined Crack on Wall No. 4 of Space 5, Fifth Face, Ground Floor, Tripoliya Gate, Approx. Width = 0.6mm, Approx. Length = 0.5m. Distance from Wall 1 = 1.2m, Height from Floor = 0m.

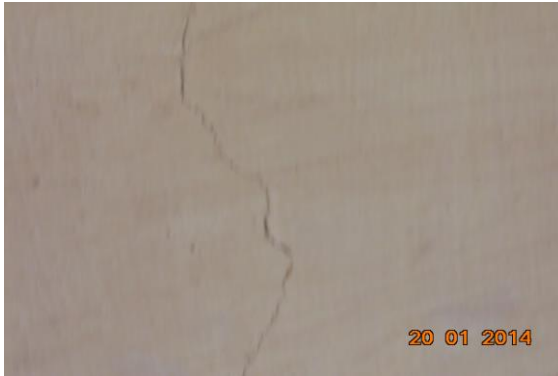
Photo 24

Inclined Crack on Wall No. 4 of Space 5, Fifth Face, Ground Floor, Tripoliya Gate, Approx. Width = 0.4mm, Approx. Length = 1.3m. Distance from Wall 1 = 1.3m, Height from Floor = 0.3m.

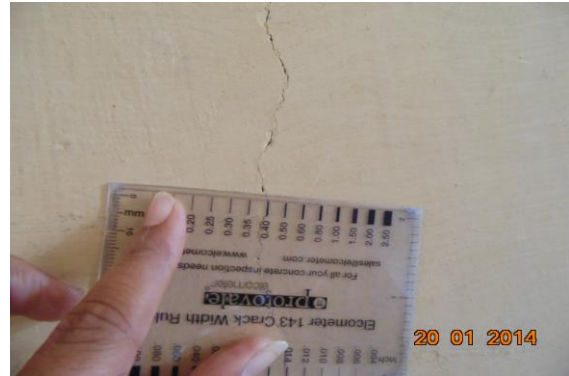
Photo 24A

Inclined Crack on Wall No. 4 of Space 5, Fifth Face, Ground Floor, Tripoliya Gate, Approx. Width = 0.4mm, Approx. Length = 1.3m. Distance from Wall 1 = 1.3m, Height from Floor = 0.3m.

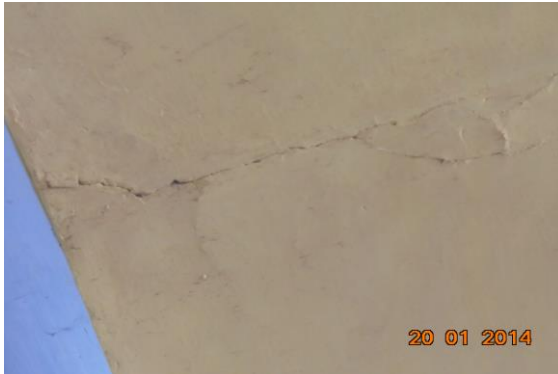
Photo 25

Horizontal Crack on Roof of Sixth Face, Ground Floor, Tripoliya Gate, Approx. Width = 3mm, Approx. Length = 2m. Distance from Wall 1 = 2.2m, Height from Floor = 8.5m.

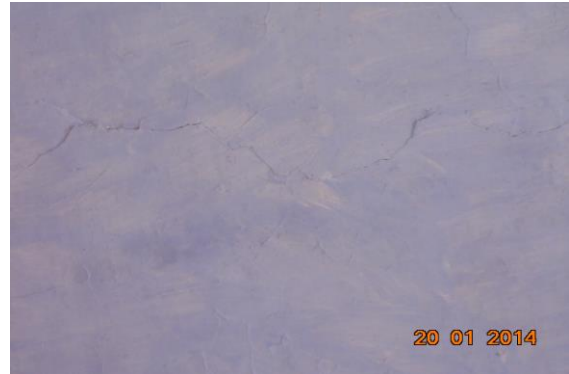
Photo 26

Inclined Crack on Roof of Space 7, Ground Floor, Tripoliya Gate, Approx. Width = 0.6mm, Approx. Length = 3.5m. Distance from Wall 1 = 2.2m, Height from Floor = 8.5m.

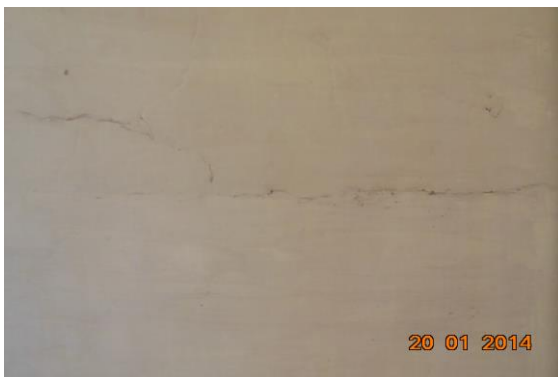
Photo 27

Inclined Crack on Wall No. 1 of Space 3, Ground Floor, Tripoliya Gate, Approx. Width = 0.6mm, Approx. Length = 1.55m. Distance from Gate 5 = 1.55m, Height from Floor = 1.35m.

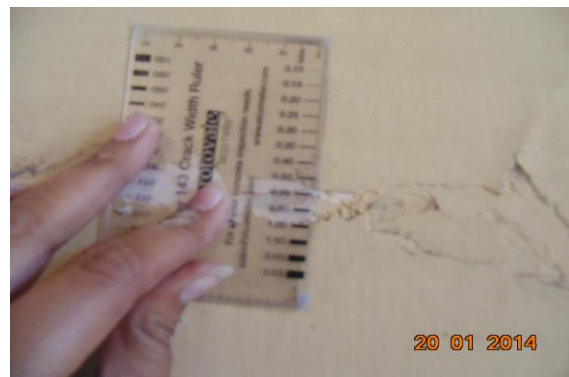
Photo 27A

Inclined Crack on Wall No. 1 of Space 3, Ground Floor, Tripoliya Gate, Approx. Width = 0.6mm, Approx. Length = 1.55m. Distance from Gate 5 = 1.55m, Height from Floor = 1.35m.

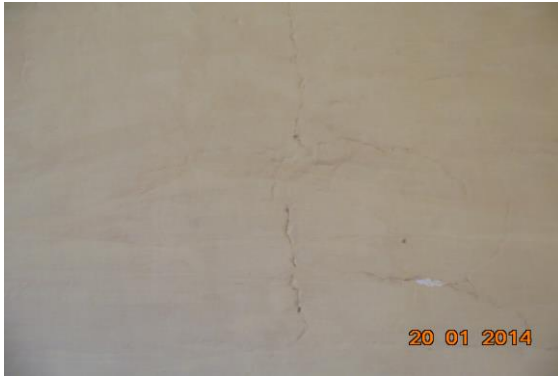
Photo 28

Vertical Crack on Wall No. 1 of Space 3, Ground Floor, Tripoliya Gate, Approx. Width = 0.8mm, Approx. Length = 1.35m. Distance from Gate 5 = 2.65m, Height from Floor = 1.4m.

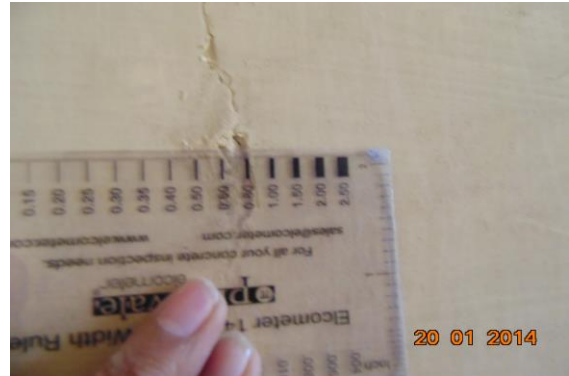
Photo 28A

Vertical Crack on Wall No. 1 of Space 3, Ground Floor, Tripoliya Gate, Approx. Width = 0.8mm, Approx. Length = 1.35m. Distance from Gate 5 = 2.65m, Height from Floor = 1.4m.

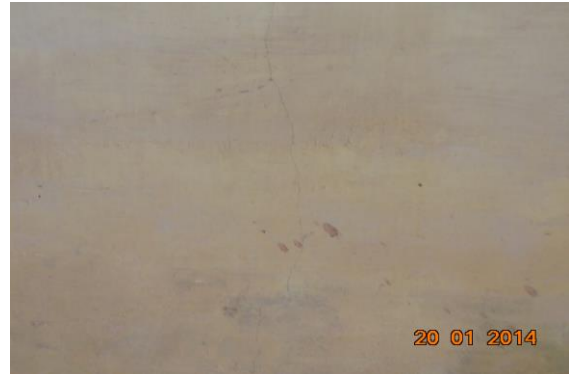
Photo 29A

Inclined Crack on Wall No. 1 of Space 3, Ground Floor, Tripoliya Gate, Approx. Width = 0.4mm, Approx. Length = 1.4m. Distance from Gate 5 = 2.85m, Height from Floor = 0m.

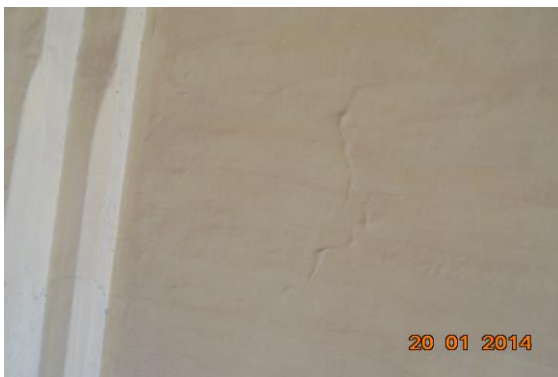
Photo 30

Inclined Crack on Wall No. 1 of Space 3, Ground Floor, Tripoliya Gate, Approx. Width = 0.8mm, Approx. Length = 3.2m. Distance from Gate 5 = 0m, Height from Floor = 1.4m.

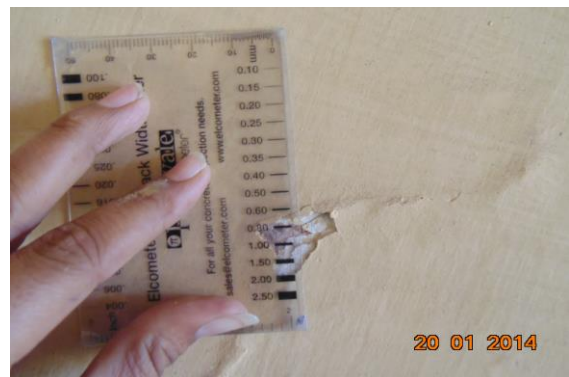
Photo 30A

Inclined Crack on Wall No. 1 of Space 3, Ground Floor, Tripoliya Gate, Approx. Width = 0.8mm, Approx. Length = 3.2m. Distance from Gate 5 = 0m, Height from Floor = 1.4m.

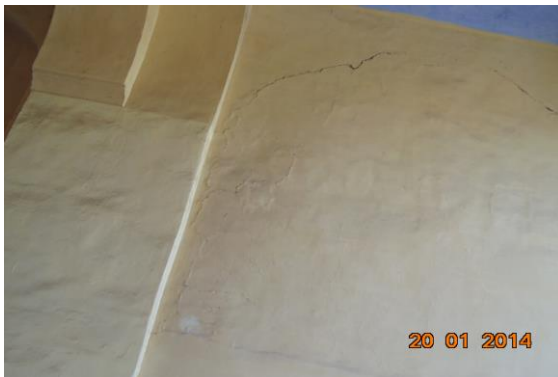
Photo 33

Inclined Crack on Wall No. 1 of Between Gate 5 & Gate 6, Ground Floor, Tripoliya Gate, Approx. Width = 20mm, Approx. Length = 12m. Distance from Gate 6 = 0m, Height from Floor = 1.65m.

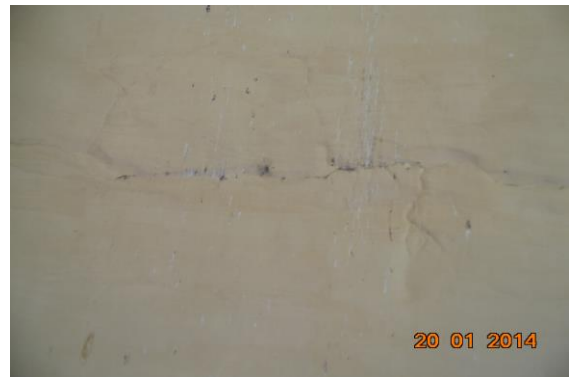
Photo 34

Horizontal Crack on Wall No. 2 of Between Gate 5 & Gate 6, Ground Floor, Tripoliya Gate, Approx. Width = 1mm, Approx. Length = 5m. Distance from Gate 6 = 0m, Height from Floor = 1.8m.

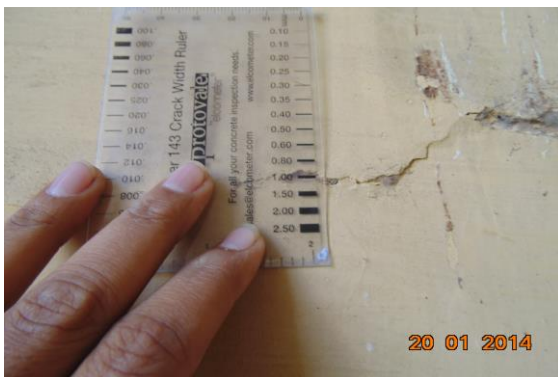
Photo 34A

Horizontal Crack on Wall No. 2 of Between Gate 5 & Gate 6, Ground Floor, Tripoliya Gate, Approx. Width = 1mm, Approx. Length = 5m. Distance from Gate 6 = 0m, Height from Floor = 1.8m.

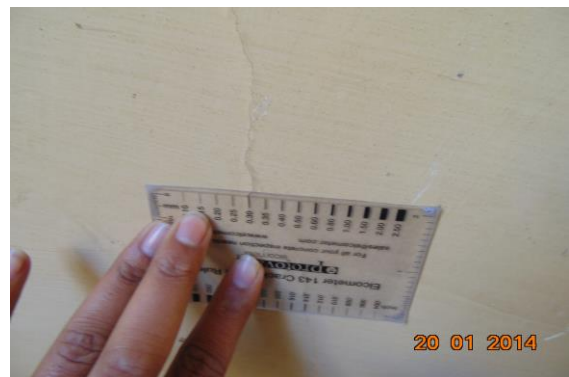
Photo 35

Inclined Crack on Wall No. 2 of Between Gate 5 & Gate 6, Ground Floor, Tripoliya Gate, Approx. Width = 0.3mm, Approx. Length = 1.5m. Distance from Gate 6 = 1.15m, Height from Floor = 0m.

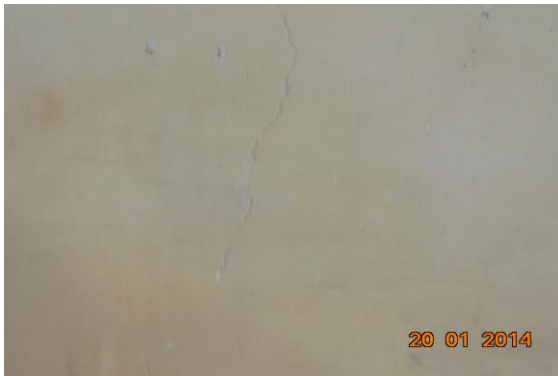
Photo 36

Inclined Crack on Wall No. 2 of Between Gate 5& Gate 6, Ground Floor, Tripoliya Gate, Approx. Width = 0.3mm, Approx. Length = 1.5m. Distance from Gate 6 = 1.15m, Height from Floor = 0m.

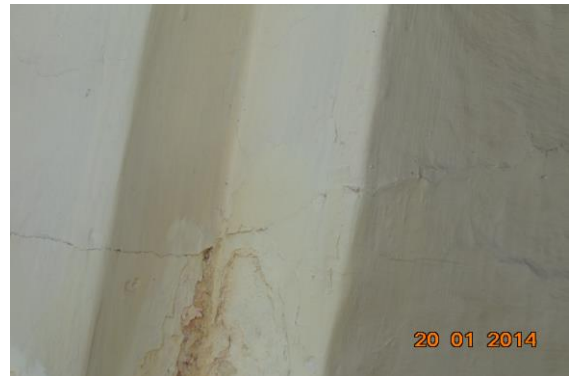
Photo 37

Inclined Crack on Wall No. 2 of Between Gate 5& Gate 12, Ground Floor, Tripoliya Gate, Approx. Width = 0.8mm, Approx. Length = 2.4m. Distance from Gate 6 = 0m, Height from Floor = 1.5m.

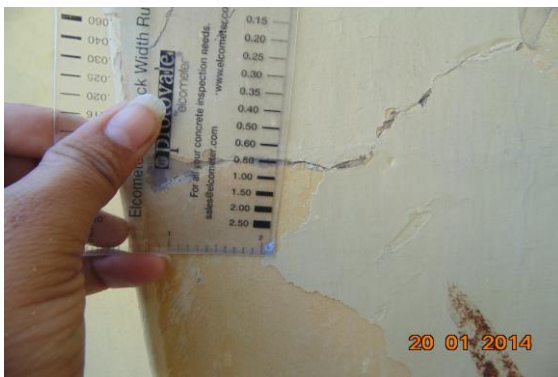
Photo 37A

Inclined Crack on Wall No. 2 of Between Gate 5& Gate 12, Ground Floor, Tripoliya Gate, Approx. Width = 0.8mm, Approx. Length = 2.4m. Distance from Gate 6 = 0m, Height from Floor = 1.5m.

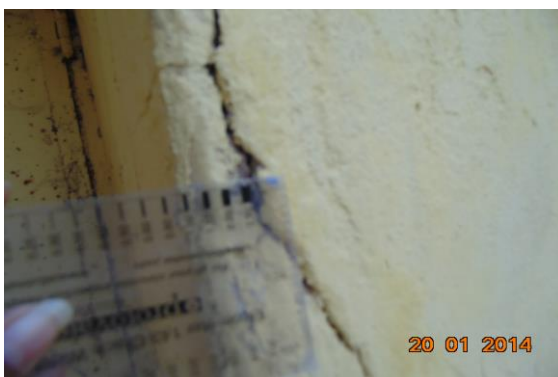
Photo 38

Inclined Crack on of Inside back of Gate, Ground Floor, Tripoliya Gate, Approx. Width = 2.5mm, Approx. Length = 1m. Distance from = Corner, Height from Floor = 0.9m.

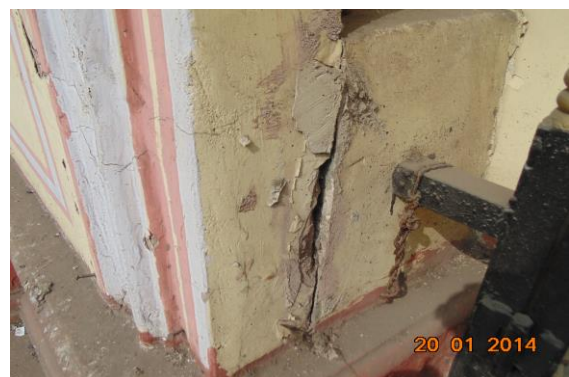
Photo 39

Inclined Crack on of Inside back of Gate, Ground Floor, Tripoliya Gate, Approx. Width = 2.5mm, Approx. Length = 1m. Distance from = Corner, Height from Floor = 0.9m.

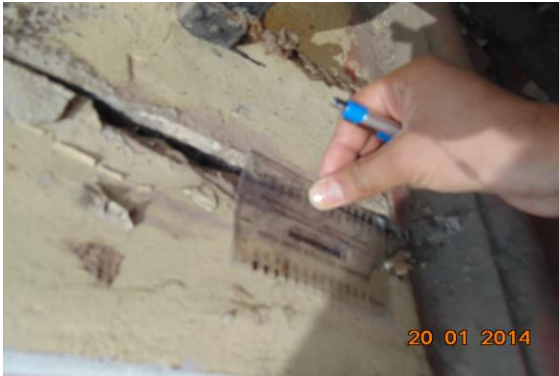
Photo 40

Vertical Crack on Outer Wall of Room No. 3, Left Side of Gate Ground Floor, Tripoliya Gate, Approx. Width = 5mm, Approx. Length = 1m. Distance from Wall 1, Gate = 2m, Height from Floor = 1m.

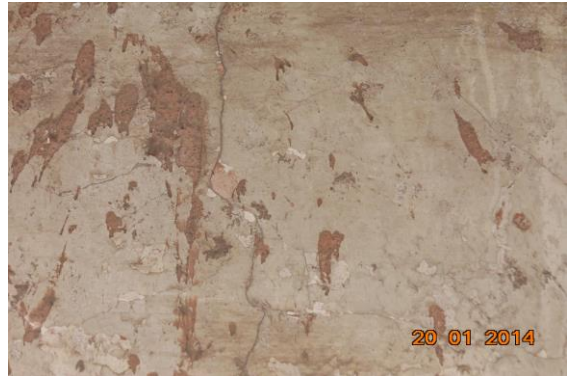
Photo 40A

Vertical Crack on Outer Wall of Room No. 3, Left Side of Gate Ground Floor, Tripoliya Gate, Approx. Width = 5mm, Approx. Length = 1m. Distance from Wall 1, Gate = 2m, Height from Floor = 1m.

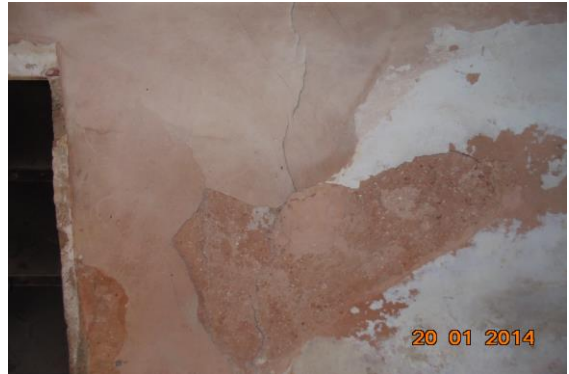
Photo 42

Inclined Crack on Wall No. 4 of Varanda 1 & Stone Bocks, First Floor, Tripoliya Gate, Approx. Width = 0.8mm, Approx. Length = 2m. Distance from Wall 2 = 0.3m, Height from Floor = 0.6m.

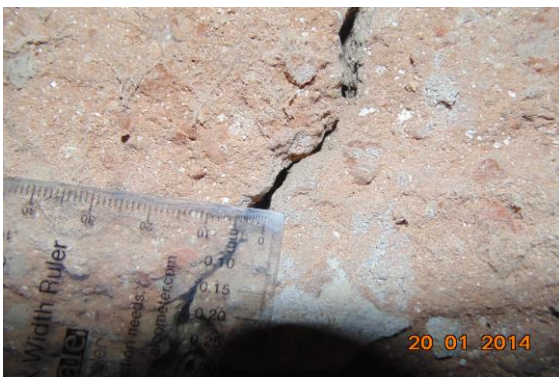
Photo 43

Inclined Crack on Wall No. 3 of Varanda 1 & Stone Bocks, First Floor, Tripoliya Gate, Approx. Width = 4mm, Approx. Length = 2.5m. Distance from Wall 2 = 2.5m, Height from Floor = 0m.

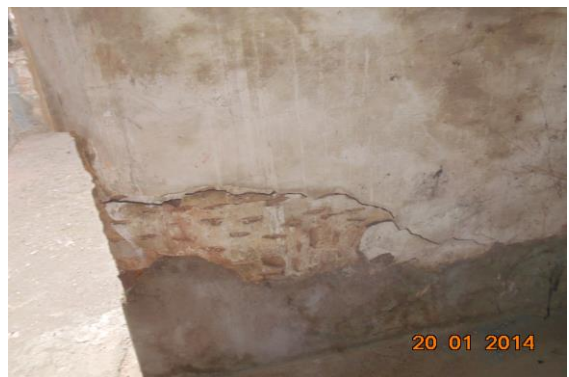
Photo 43A

Inclined Crack on Wall No. 3 of Varanda 1 & Stone Bocks, First Floor, Tripoliya Gate, Approx. Width = 4mm, Approx. Length = 2.5m. Distance from Wall 2 = 2.5m, Height from Floor = 0m.

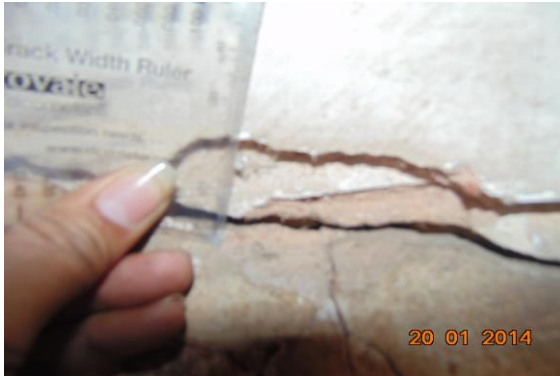
Photo 44

Inclined Crack on Wall No. 2 of Room No. 1, First Floor, Tripoliya Gate, Approx. Width = 5mm, Approx. Length = 1.2m. Distance from Wall 4 = 0.35m, Height from Floor = 0.3m.

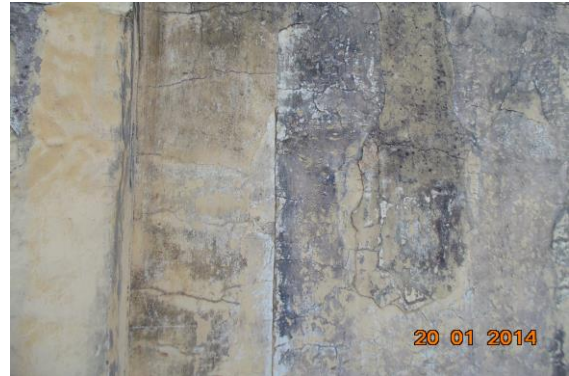
Photo 44A

Inclined Crack on Wall No. 2 of Room No. 1, First Floor, Tripoliya Gate, Approx. Width = 5mm, Approx. Length = 1.2m.
Distance from Wall 4 = 0.35m, Height from Floor = 0.3m.

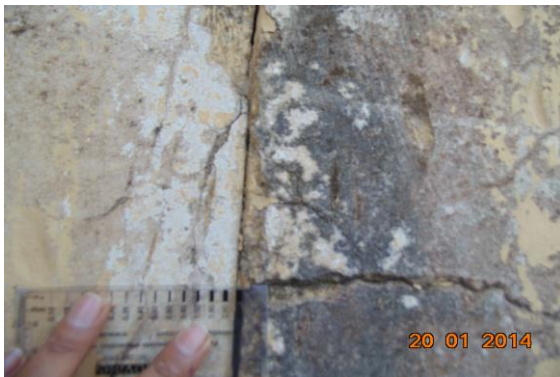
Photo 45

Vertical Crack on Wall No. 2 of , Tripoliya Gate, Terrace, Approx. Width = 2.5mm, Approx. Length = 3m.
Distance from Wall 3 = 14.86m, Height from Floor = 0m.

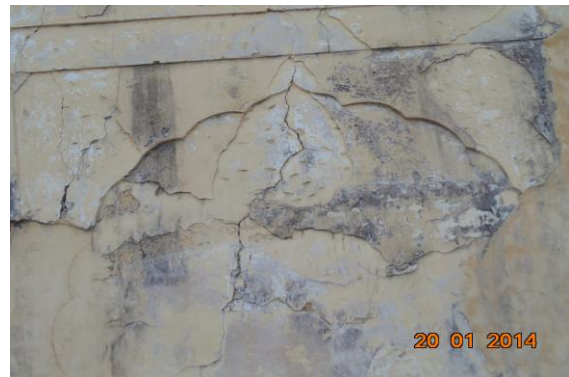
Photo 46

Vertical Crack on Wall No. 2 of , Tripoliya Gate, Terrace, Approx. Width = 2.5mm, Approx. Length = 3m.
Distance from Wall 3 = 14.86m, Height from Floor = 0m.

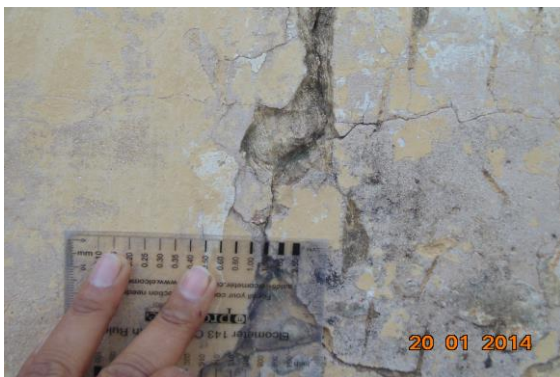
Photo 47

Inclined Crack on Wall No. 2 of , Tripoliya Gate, Terrace, Approx. Width = 1.5mm, Approx. Length = 5m.
Distance from Wall 3 = 16m, Height from Floor = 0m.

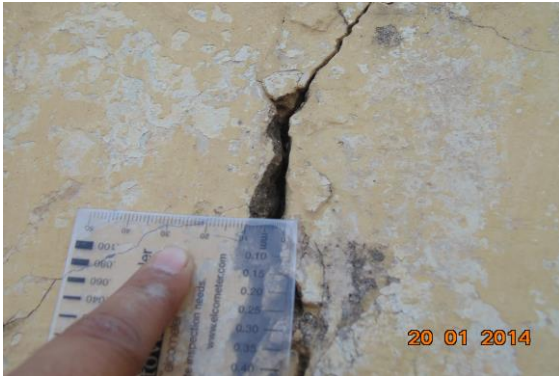
Photo 49

Inclined Crack on Wall No. 2 of , Tripoliya Gate, Terrace, Approx. Width = 10mm, Approx. Length = 1m.
Distance from Wall 3 = 16.5m, Height from Floor = 1.7m.

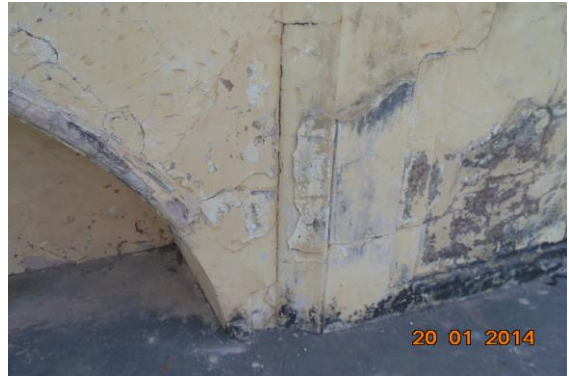
Photo 50

Inclined Crack on Wall No. 2 of , Tripoliya Gate, Terrace, Approx. Width = 10mm, Approx. Length = 1m.
Distance from Wall 3 = 16.5m, Height from Floor = 1.7m.

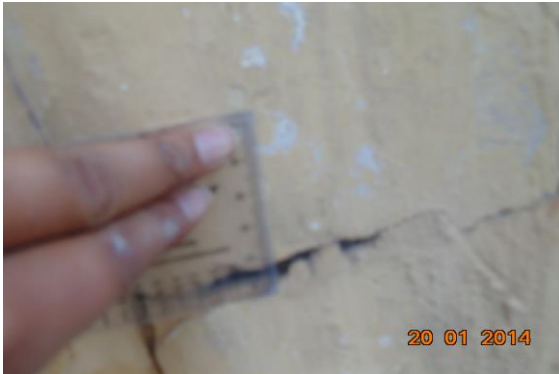
Photo 51

Vertical Crack on Wall No. 2 of , Tripoliya Gate, Terrace, Approx. Width = 5mm, Approx. Length = 3m.
Distance from Wall 3 = 17m, Height from Floor = 0m.

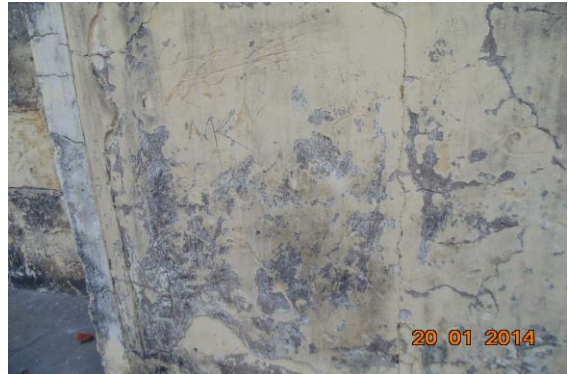
Photo 51A

Vertical Crack on Wall No. 2 of , Tripoliya Gate, Terrace, Approx. Width = 5mm, Approx. Length = 3m.
Distance from Wall 3 = 17m, Height from Floor = 0m.

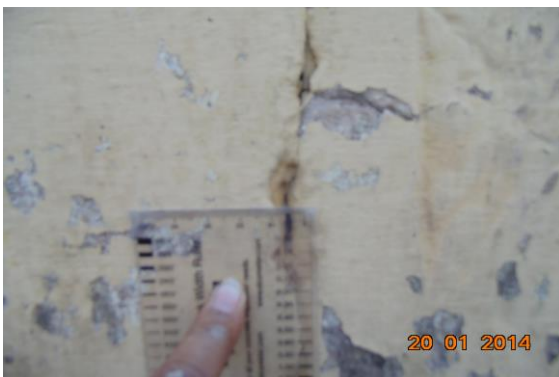
Photo 52

Inclined Crack on Wall No. 2 of , Tripoliya Gate, Terrace, Approx. Width = 10mm, Approx. Length = 5m.
Distance from Wall 3 = 23m, Height from Floor = 0m.

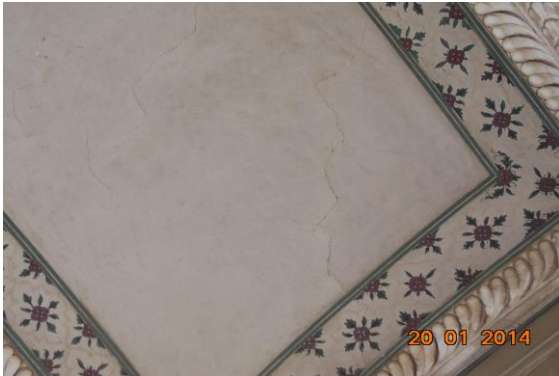
Photo 53

Inclined Crack on Roof of Minarets, Tripoliya Gate, Terrace, Approx. Width = 0.6mm, Approx. Length = 1m.
Distance from Wall 3 = 1.2m, Height from Floor = 3m.

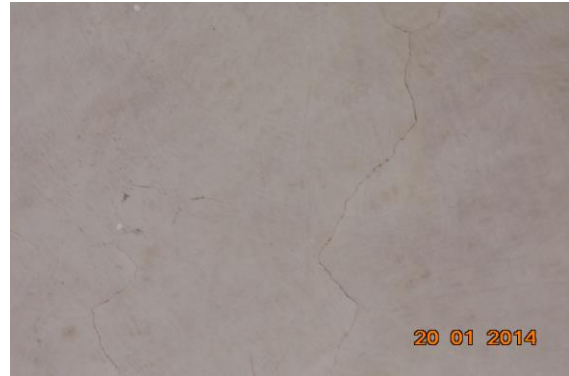
Photo 54

Inclined Crack on Roof of Minarets, Tripoliya Gate, Terrace, Approx.
Width = 0.6mm, Approx. Length = 1m.
Distance from Wall 2 = 0m, Height from Floor = 3.2m.

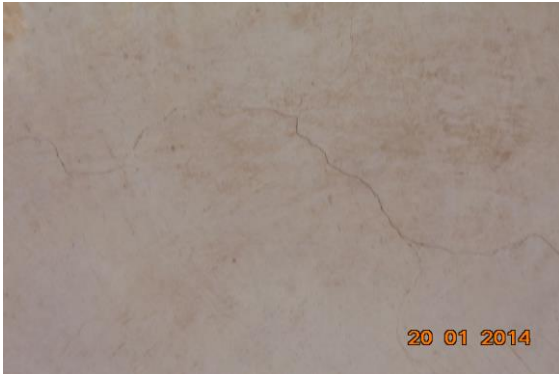
Photo 55

Inclined Crack on Roof of Minarets, Tripoliya Gate, Terrace, Approx.
Width = 0.4mm, Approx. Length = 1.5m.
Distance from Wall 4 = 0m, Height from Floor = 3m.

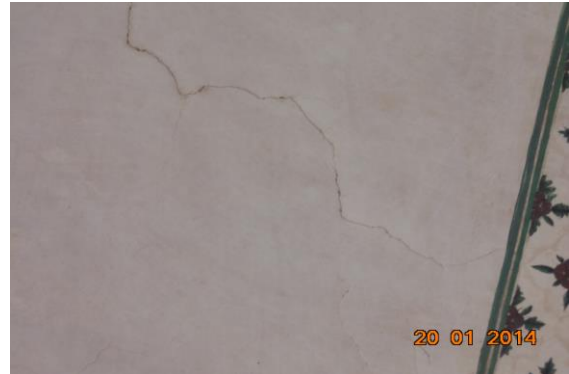
Photo 56

Inclined Crack on Roof of Minarets, Tripoliya Gate, Terrace, Approx.
Width = 0.4mm, Approx. Length = 2m.
Distance from Wall 3 = 0.8m, Height from Floor = 3m.

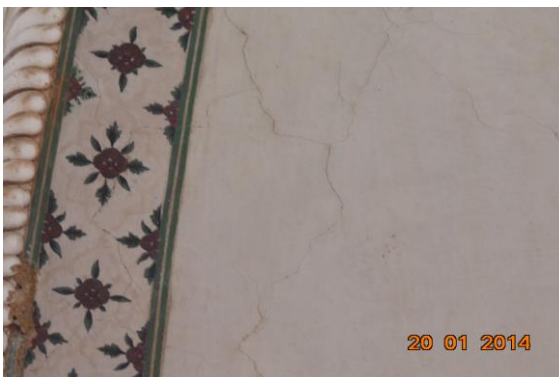
Photo 57

Inclined Crack on Roof of Minarets, Tripoliya Gate, Terrace, Approx.
Width = 0.8mm, Approx. Length = 2m.
Distance from Wall 4 = 0m, Height from Floor = 3.5m.

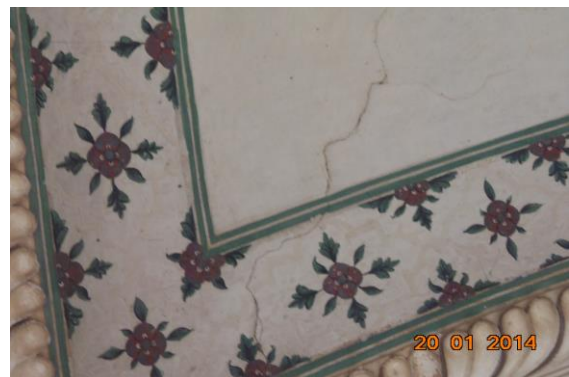
Photo 58

Inclined Crack on Roof of Minarets, Tripoliya Gate, Terrace, Approx.
Width = 0.4mm, Approx. Length = 2.5m.
Distance from Wall 1 = 0m, Height from Floor = 3.5m.

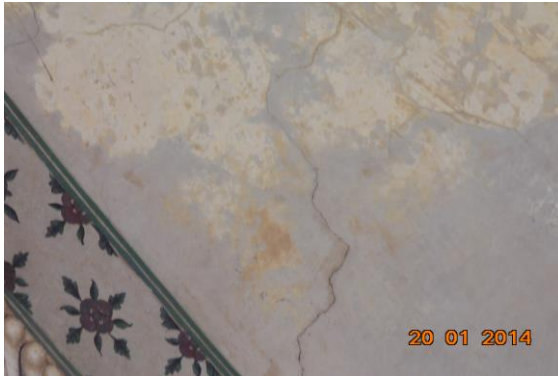
Photo 59

Inclined Crack on Roof of Minarets, Tripoliya Gate, Terrace, Approx.
Width = 0.8mm, Approx. Length = 2m.
Distance from Wall 1 = 0m, Height from Floor = 3m.

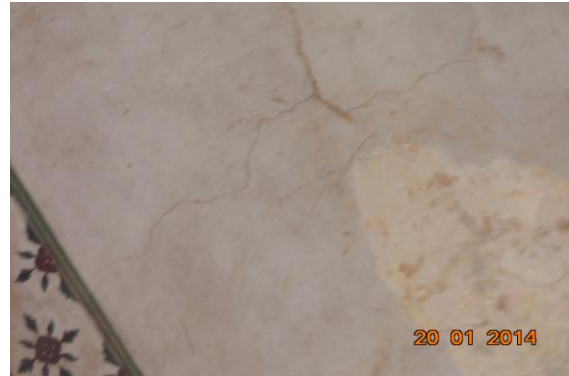
Photo 60

Inclined Crack on Roof of Minarets, Tripoliya Gate, Terrace, Approx.
Width = 0.8mm, Approx. Length = 3m.
Distance from Wall 3 = 0m, Height from Floor = 3m.

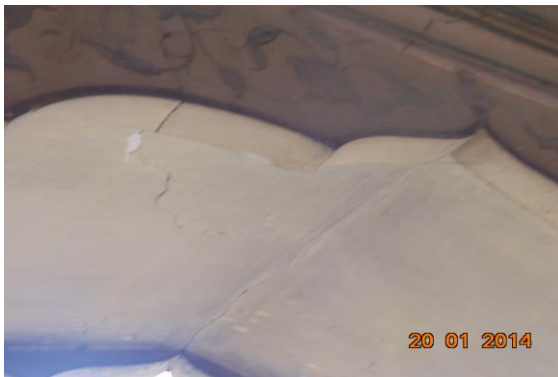
Photo 61

Inclined Crack on Roof of Minarets, Tripoliya Gate, Terrace, Approx.
Width = 0.6mm, Approx. Length = 2m.
Distance from Wall 3 = 0m, Height from Floor = 3.5m.

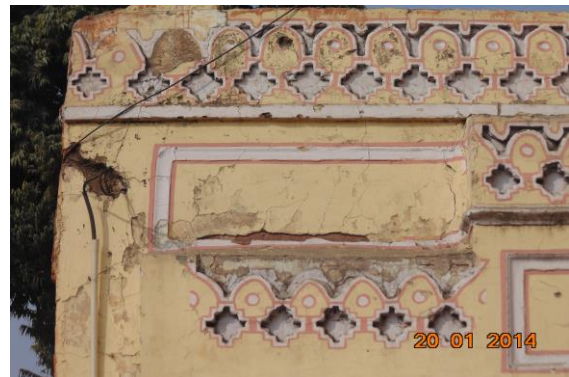
Photo 62

Inclined Crack on Wall No. 3 & Roof of Minarets, Tripoliya Gate,
Terrace, Approx. Width = 0.6mm, Approx. Length = 3m.
Distance from Wall 1 = 4m, Height from Floor = 2.3m.

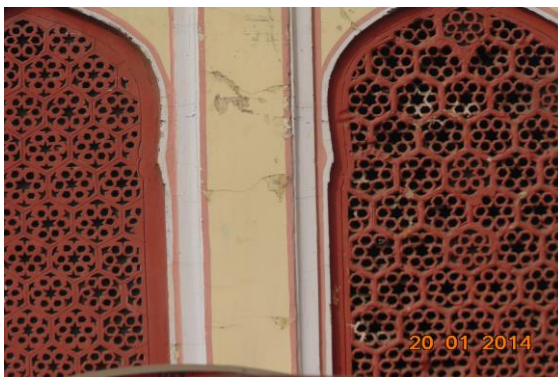
Photo 63

Peeling of Plaster on Wall No. 1 of Ground Floor, Tripoliya Gate

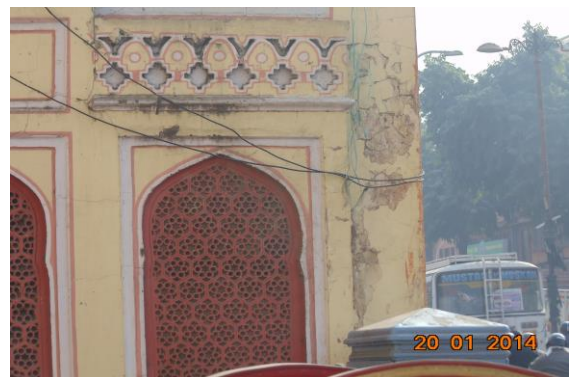
Photo 64

Peeling of Plaster on Wall No. 1 of Ground Floor, Tripoliya Gate

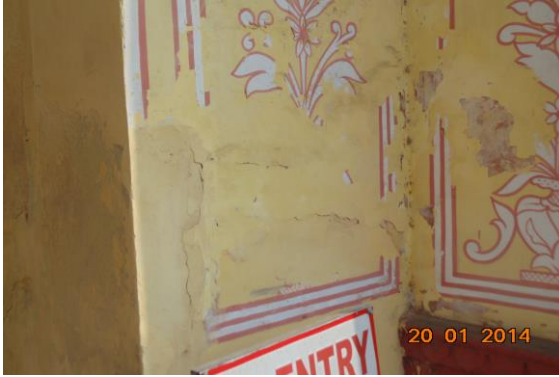
Photo 65

Peeling of Plaster on Wall No. 2 of Ground Floor, Tripoliya Gate

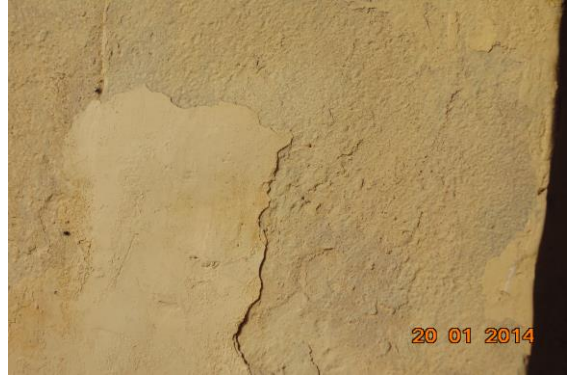
Photo 66

Peeling of Plaster on Wall No. 2 of First Face of Ground Floor, Tripoliya Gate

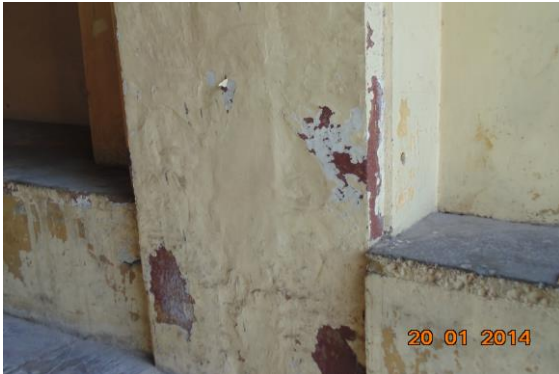
Photo 67

Peeling of Plaster on Wall No. 1 of First Face of Ground Floor, Tripoliya Gate

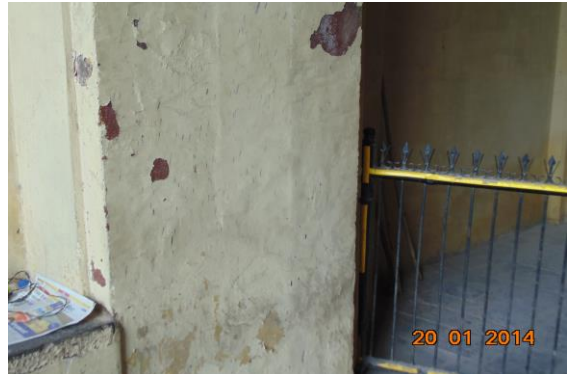
Photo 68

Peeling of Plaster on Wall No. 2 of Second Face of Ground Floor, Tripoliya Gate

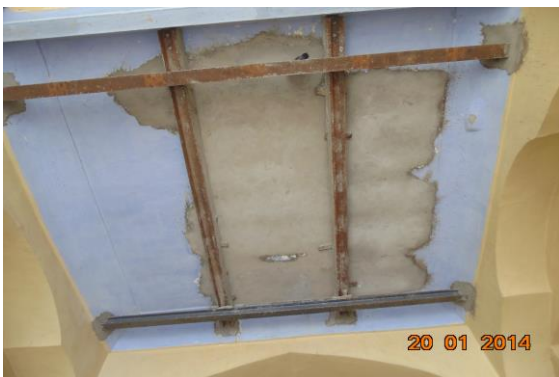
Photo 69

Peeling of Plaster on Wall No. 1 of Second Face of Ground Floor, Tripoliya Gate

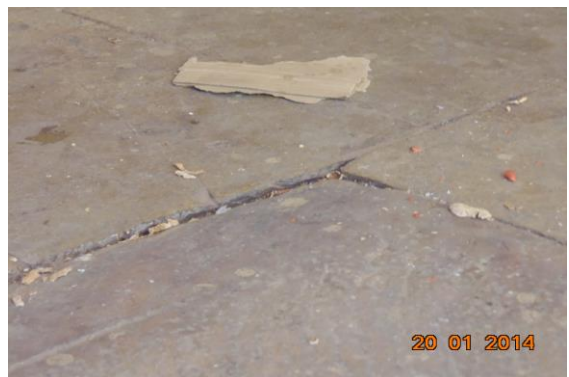
Photo 70

Peeling of Plaster on Roof of Second Face of Ground Floor, Tripoliya Gate

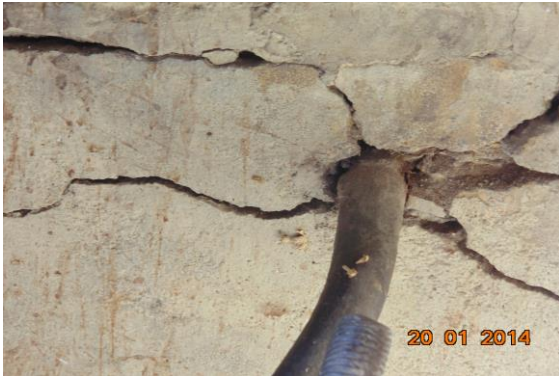
Photo 71

Peeling of Plaster on Floor of Room No. 1 of Ground Floor, Tripoliya Gate

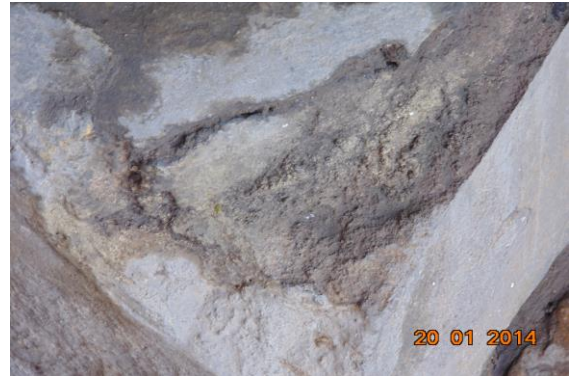
Photo 72

Peeling of Plaster on Wall No. 3 of Outer Wall of Ground Floor, Tripoliya Gate

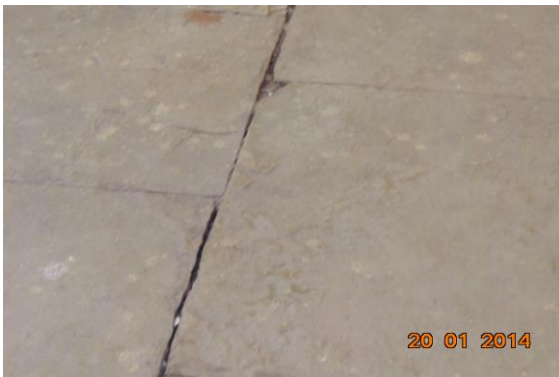
Photo 73

Damaged Portion on Step of Room No. 2 of Ground Floor, Tripoliya Gate

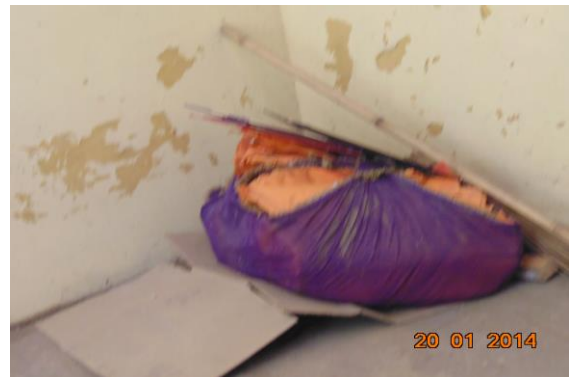
Photo 74

Peeling of Plaster on Floor of Room No. 2 of Ground Floor, Tripoliya Gate

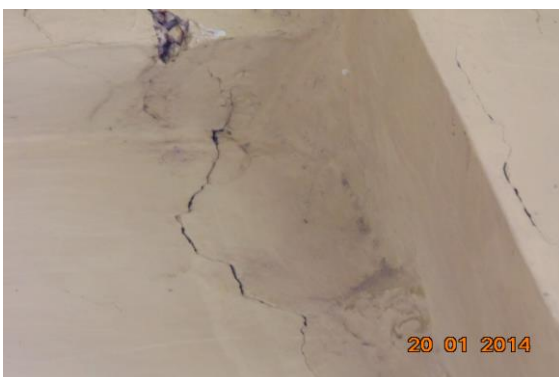
Photo 75

Peeling of Plaster on Wall No. 2 & 4 of Room No. 2 of Ground Floor, Tripoliya Gate

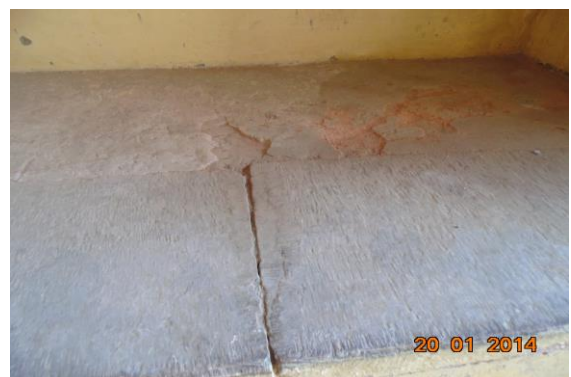
Photo 76

Peeling of Plaster of Space 4, Third Face of Ground Floor, Tripoliya Gate

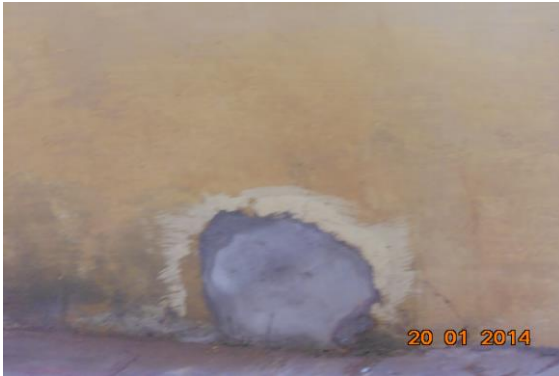
Photo 77

Peeling of Plaster on Floor of Space 4, Third Face of Ground Floor, Tripoliya Gate

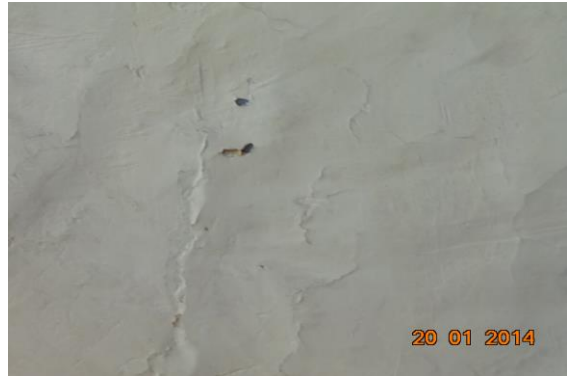
Photo 78

Peeling of Plaster on Space 2 of Fifth Face of Ground Floor, Tripoliya Gate

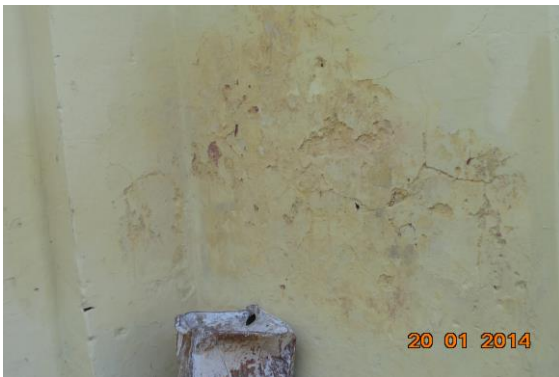
Photo 79

Peeling of Plaster on Wall No. 2 of Between Gate 5 & Gate 6 of Ground Floor, Tripoliya Gate

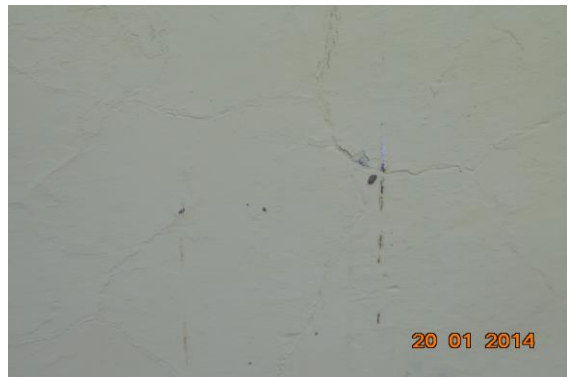
Photo 80

Peeling of Plaster on Inside back of Gate of Ground Floor, Tripoliya Gate

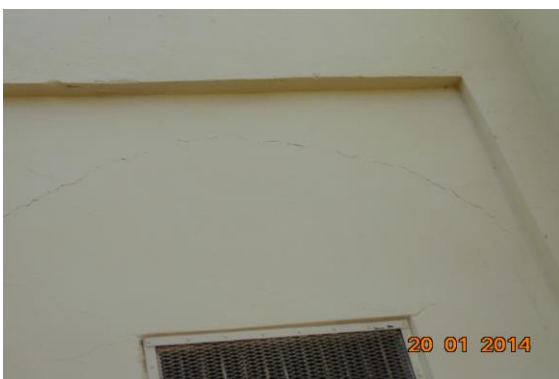
Photo 81

Plaster Crack on Inside back of Gate of Ground Floor, Tripoliya Gate

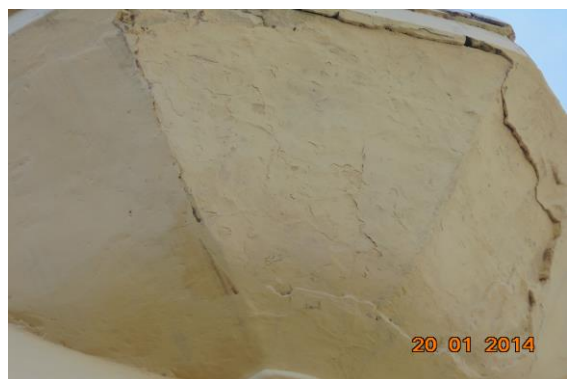
Photo 82

Peeling of Plaster on Inside back of Gate of Ground Floor, Tripoliya Gate

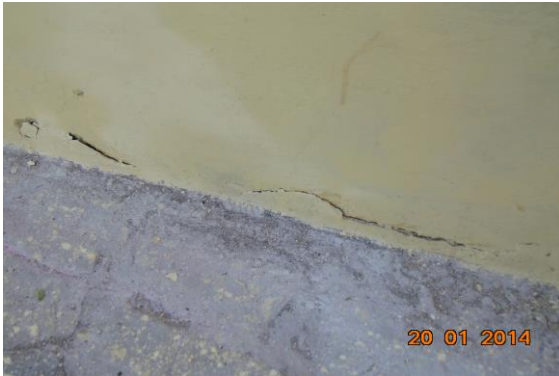
Photo 83

Peeling of Plaster on Wall No. 1 of back of Gate 5 of Ground Floor, Tripoliya Gate

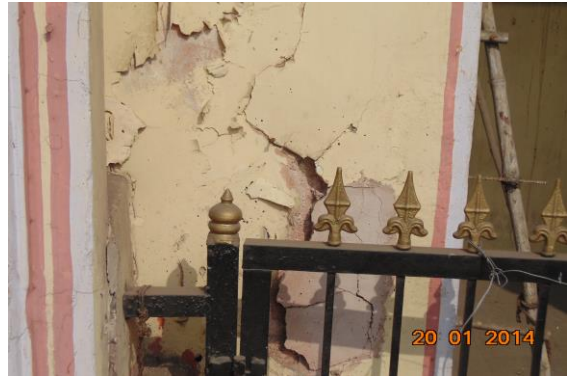
Photo 84

Peeling of Plaster on Wall No. 1 of Inside back of Gate of Ground Floor, Tripoliya Gate

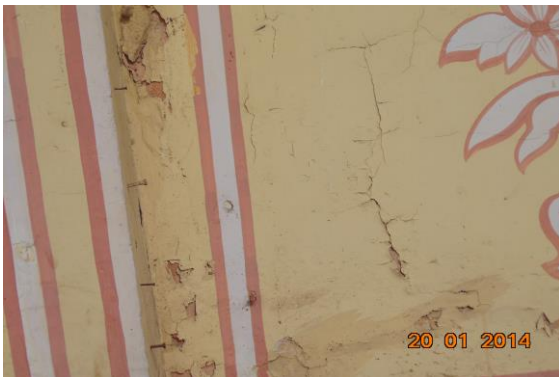
Photo 85

Peeling of Plaster on Outer Wall of Room No. 3 of Left Side of Gate Ground Floor, Tripoliya Gate

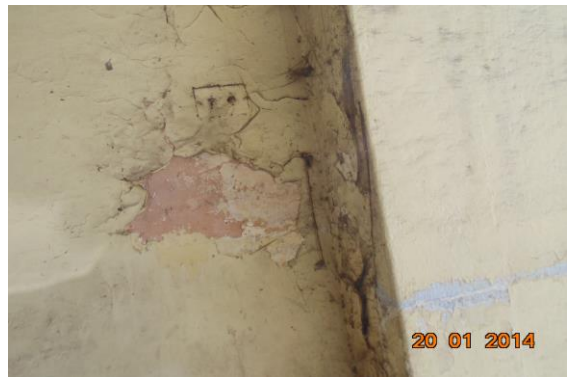
Photo 86

Peeling of Plaster on Main Gate Outer Wall of Right Side of Gate of Ground Floor, Tripoliya Gate

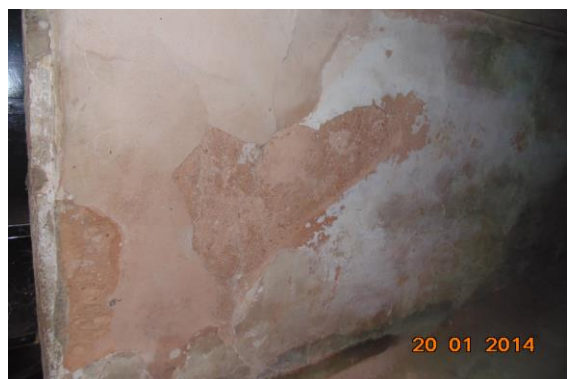
Photo 88

Peeling of Plaster on Roof of Varanda 1 & Stone Blocks of First Floor, Tripoliya Gate
