Pre Building Condition Survey Report

Name and Address of Structure :	Choti Chopar to Badi Chopar (UP Line)
---------------------------------	---------------------------------------

Name of the Project	Contract JMRC-UG1B “Design and Construction of Tunnel between Chandpole and Badi Chouper and reverse line by Shield TBM, Underground Metro Stations at Choti Chouper and Badi Chouper by Cut and Cover Methods on East West Corridor of Jaipur Metro Rail Corporation Limited .”	
Owner :

Shoping Complex - Shop No. 169-188
Tripolia Bazar
Jaipur
Unique ID: CC BC UP 0001

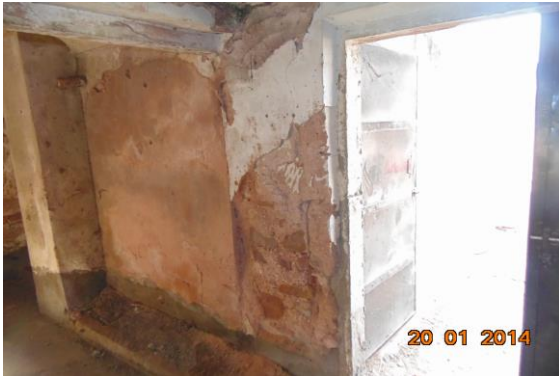
Photo 89

Peeling of Plaster on Wall No. 3 of Varanda 1 & Stone Blocks of First Floor, Tripoliya Gate

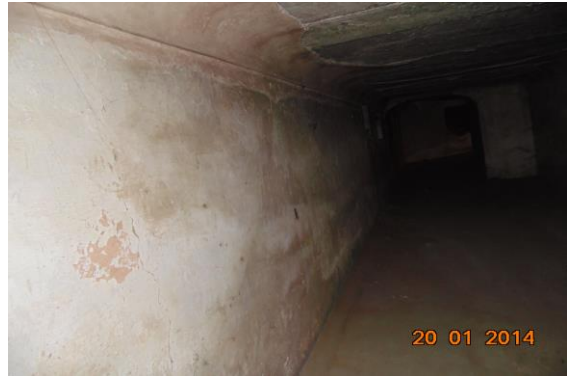
Photo 90

Peeling of Plaster on Wall No. 3 of Varanda 1 & Stone Brocks of First Floor, Tripoliya Gate

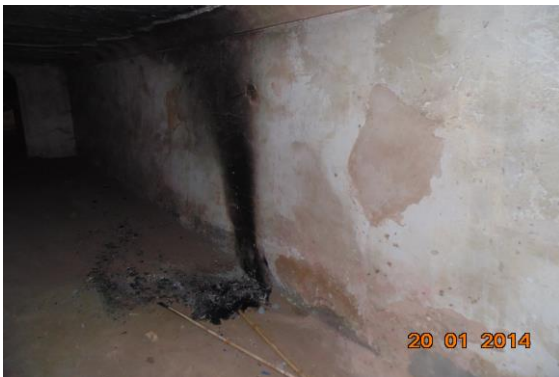
Photo 91

Peeling of Plaster on Wall No. 3 of Varanda 1 & Stone Brocks of First Floor, Tripoliya Gate

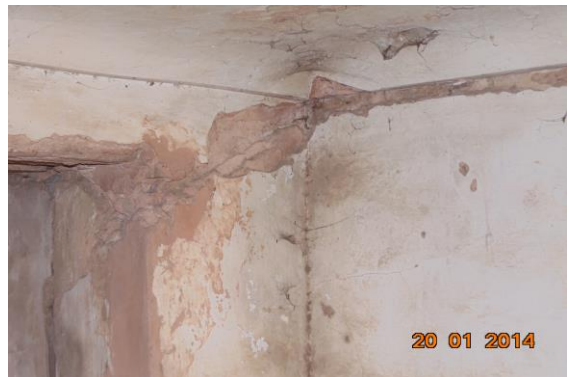
Photo 92

Peeling of Plaster on Wall No. 4 of Varanda 1 & Stone Brocks of First Floor, Tripoliya Gate

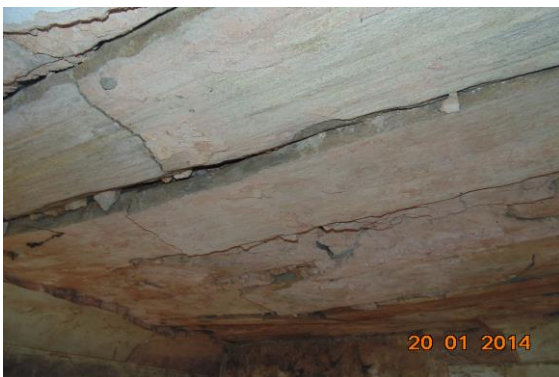
Photo 93

Peeling of Plaster on Wall No. 4 of Varanda 1 & Stone Brocks of First Floor, Tripoliya Gate

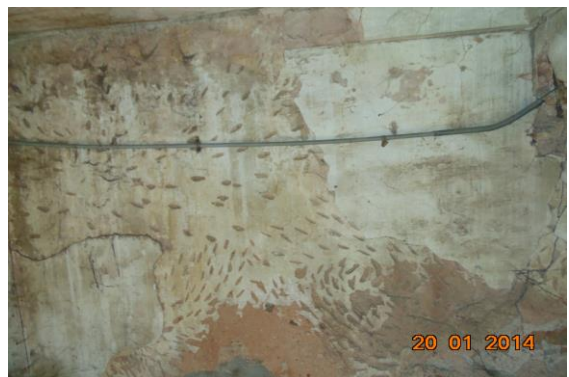
Photo 94

Damaged Portion on Roof of Room No. 1 of First Floor, Tripoliya Gate

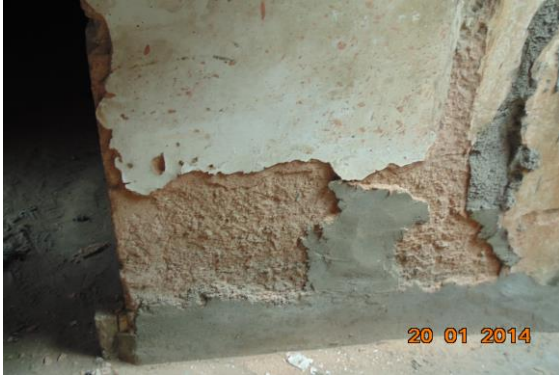
Photo 95

Peeling of Plaster on Wall No. 4 of Room No. 1 of First Floor, Tripoliya Gate

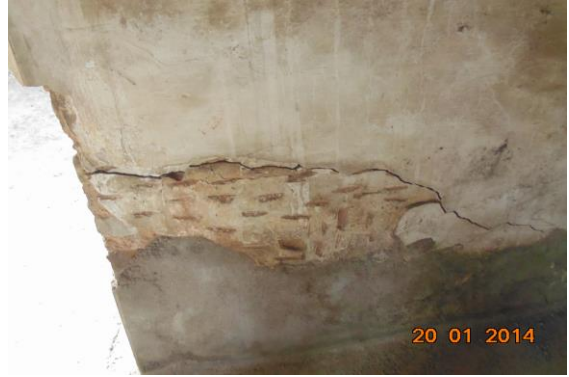
Photo 96

Peeling of Plaster on Wall No. 3 of Room No. 1 of First Floor, Tripoliya Gate

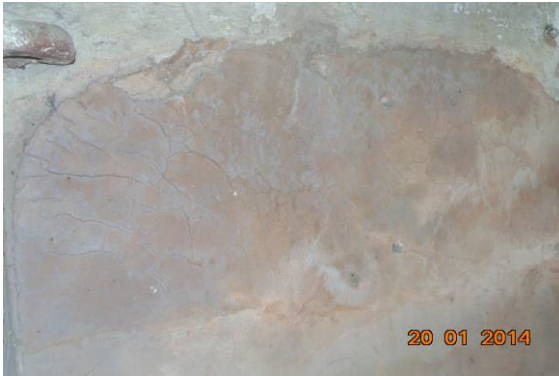
Photo 97

Peeling of Plaster on Wall No. 1 of Room No. 1 of First Floor, Tripoliya Gate

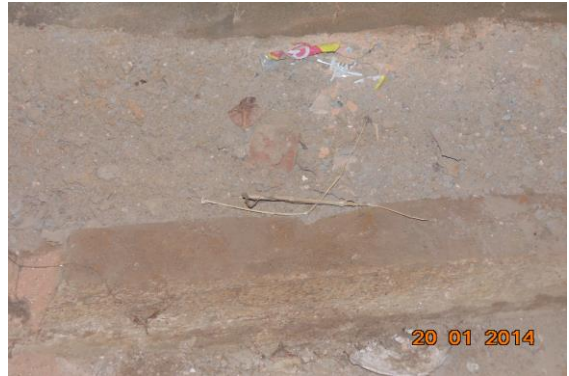
Photo 98

Peeling of Plaster on Wall No. 2 of Room No. 1 of First Floor, Tripoliya Gate

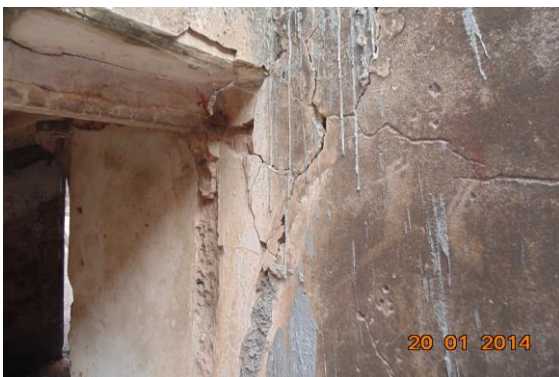
Photo 99

Peeling of Plaster on Wall No. 2 of Room No. 1 of First Floor, Tripoliya Gate

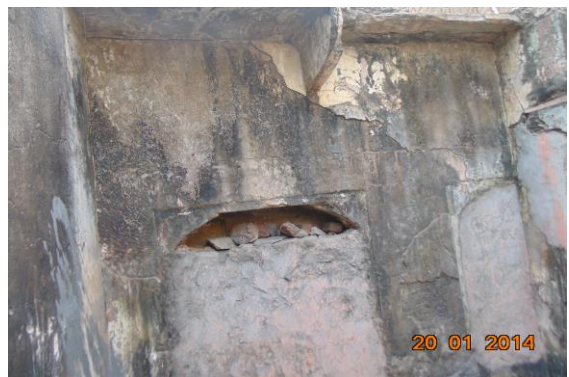
Photo 100

Damaged Portion on Wall No. 1 of Room No. 2 of First Floor, Tripoliya Gate, Open Area

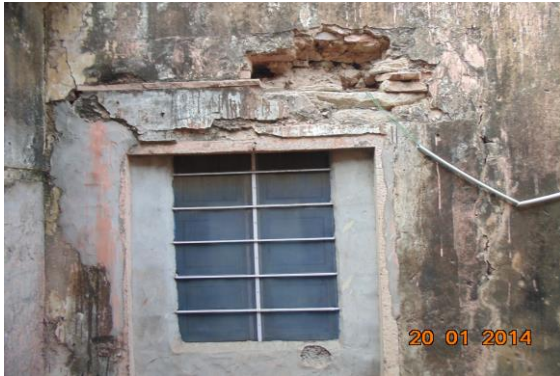
Photo 101

Peeling of Plaster on Wall No. 4 of Room No. 2 of First Floor, Tripoliya Gate, Open Area

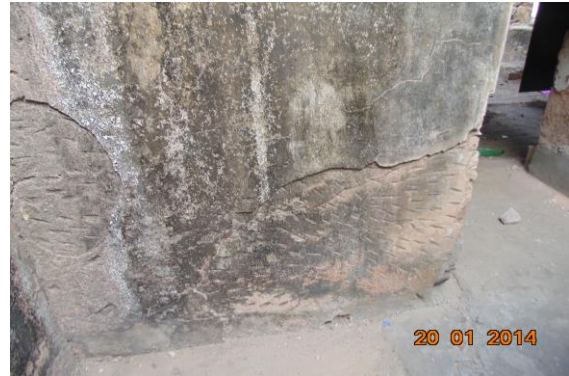
Photo 102

Damaged Portion on Wall No. 2 of Room No. 2 of First Floor, Tripoliya Gate, Open Area

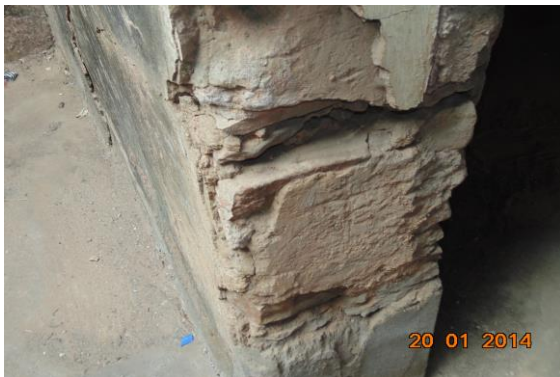
Photo 103

Peeling of Plaster on Wall No. 3 of Room No. 2 of First Floor, Tripoliya Gate, Open Area

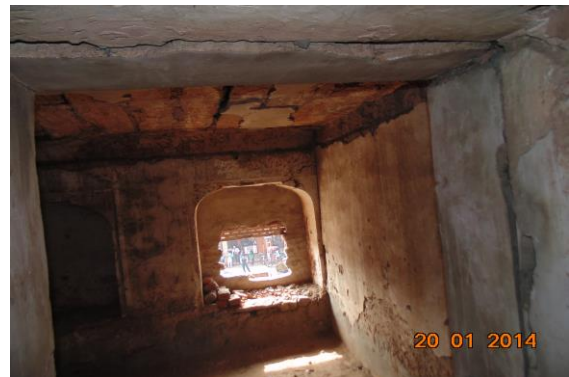
Photo 104

Damaged Portion on Wall No. 3 of Room No. 2 of First Floor, Tripoliya Gate, Open Area

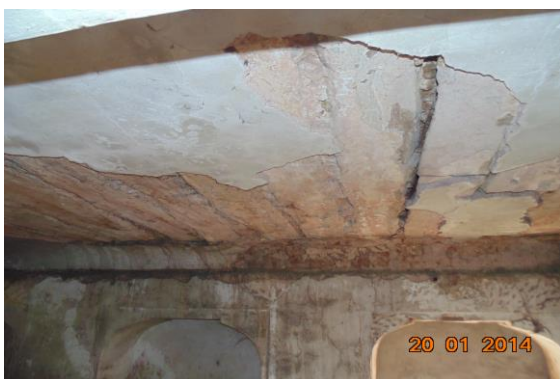
Photo 105

Damaged Portion on Gate of Room No. 3 of Gate First Floor, Tripoliya Gate

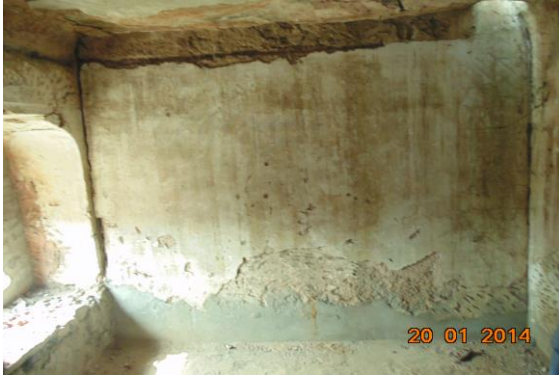
Peeling of Plaster on Wall No. 4 of Room No. 3 of First Floor, Tripoliya Gate

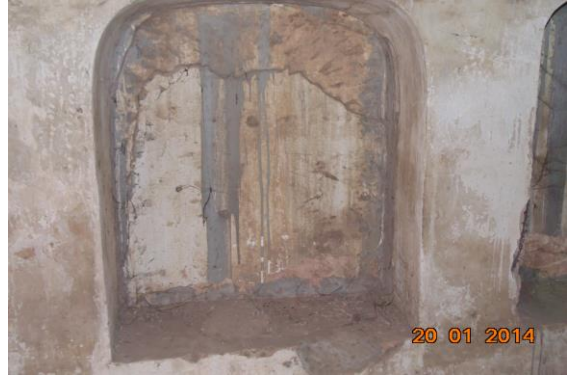
Photo 108

Peeling of Plaster on Wall No. 2 of Room No. 3 of First Floor, Tripoliya Gate

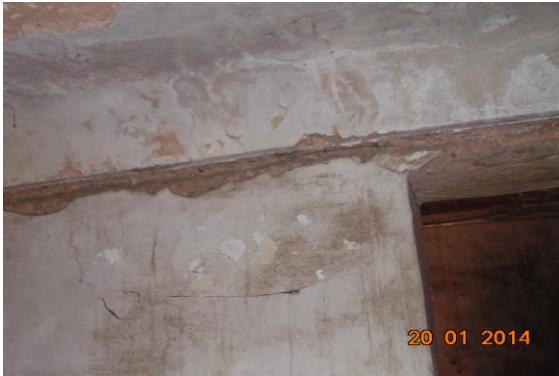
Photo 109

Peeling of Plaster on Wall No. 3 of Room No. 3 of First Floor, Tripoliya Gate

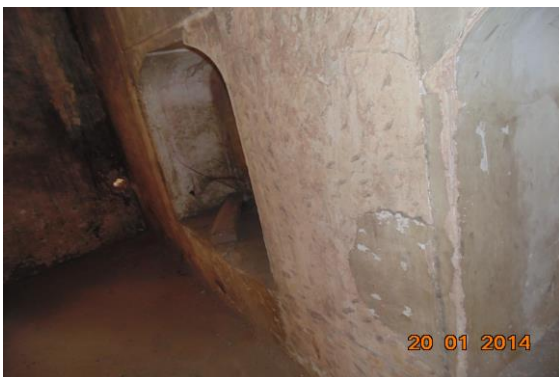
Photo 111

Damaged Portion on Roof of Room No. 4 of First Floor, Tripoliya Gate

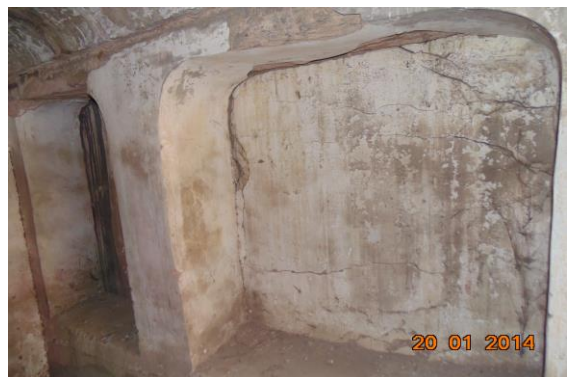
Photo 112

Damaged Portion on Wall No. 2 of Room No. 4 of First Floor, Tripoliya Gate

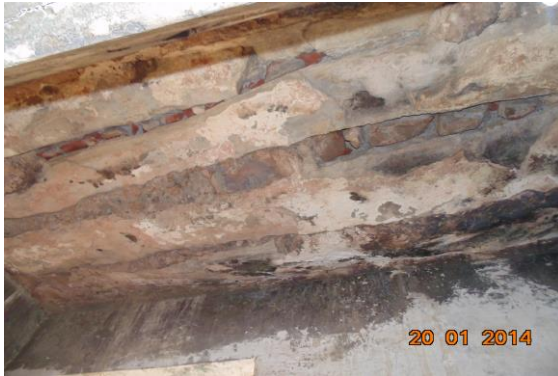
Photo 114
Peeling of Plaster on Roof of Room No. 4 of First Floor, Tripoliya Gate

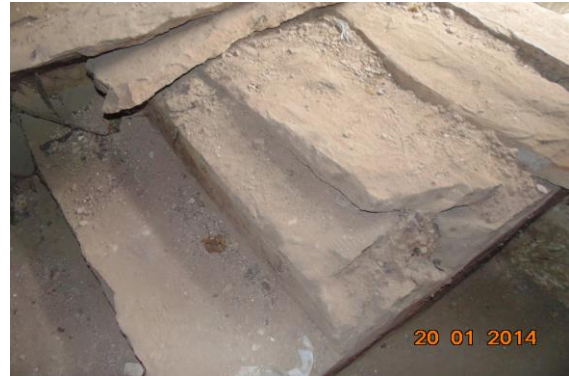
Photo 115
Damaged Portion on Stair Step of Room No. 4 of First Floor, Tripoliya Gate

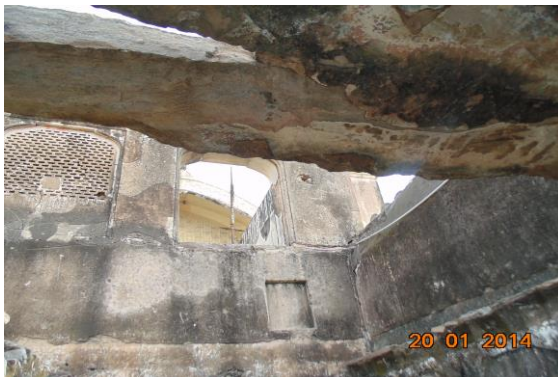
Photo 116
Damaged Portion on Roof of Room No. 4 of First Floor, Tripoliya Gate

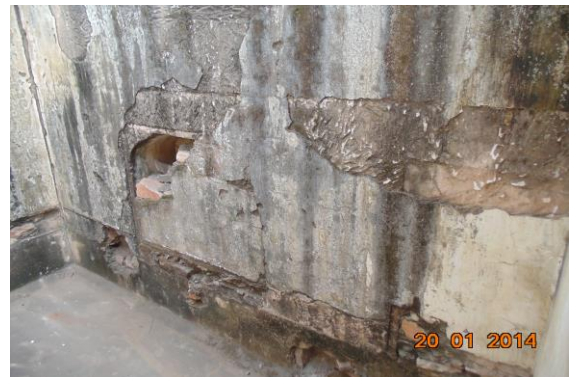
Photo 117
Peeling of Plaster on Wall No. 2 of Room No. 5 of First Floor, Tripoliya Gate

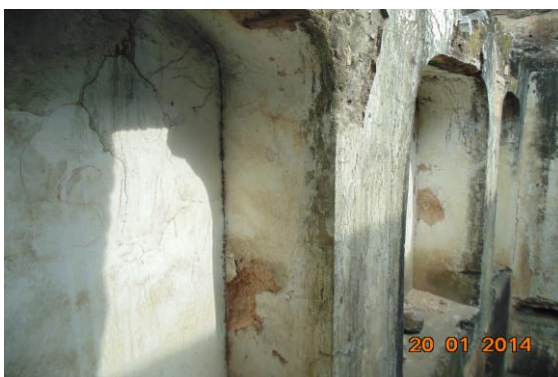
Photo 118
Peeling of Plaster on Wall No. 1 of Room No. 5 of First Floor, Tripoliya Gate

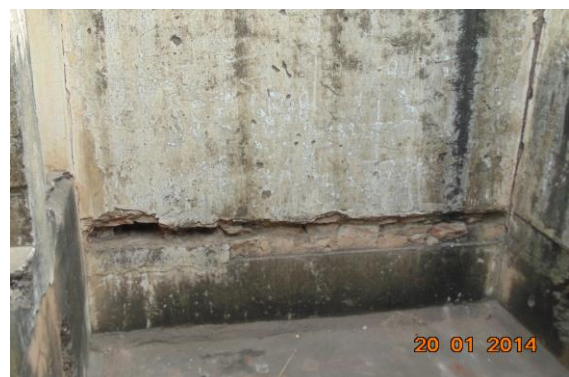
Photo 119
Peeling of Plaster on Wall No. 4 of Room No. 5 of First Floor, Tripoliya Gate

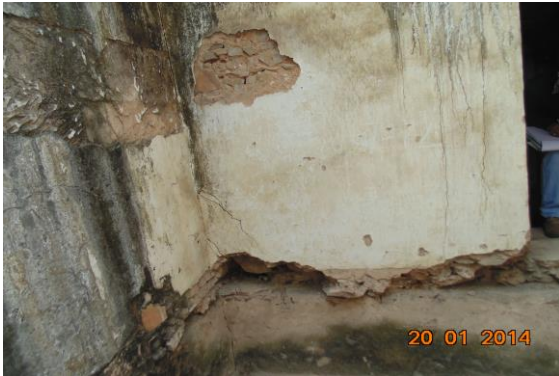
Photo 120

Peeling of Plaster on Wall No. 3 of Room No. 5 of First Floor, Tripoliya Gate

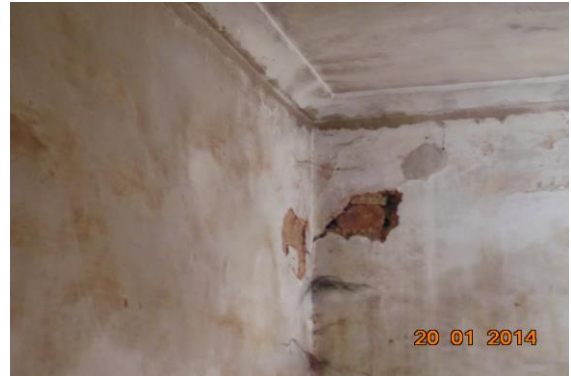
Photo 121

Peeling of Plaster on Wall No. 1, 4 & Left Side of Passage 1 of First Floor, Tripoliya Gate of Room No. 5

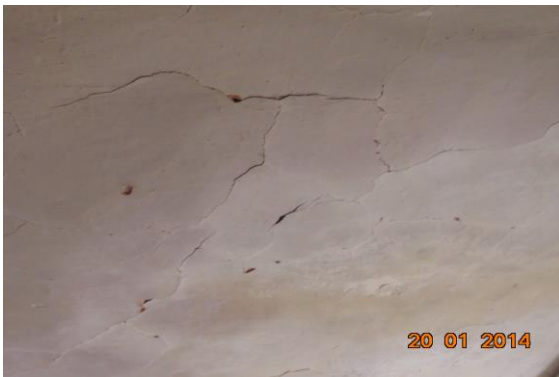
Photo 122

Plaster Crack on Roof of Passage 1 of First Floor, Tripoliya Gate of Room No. 5

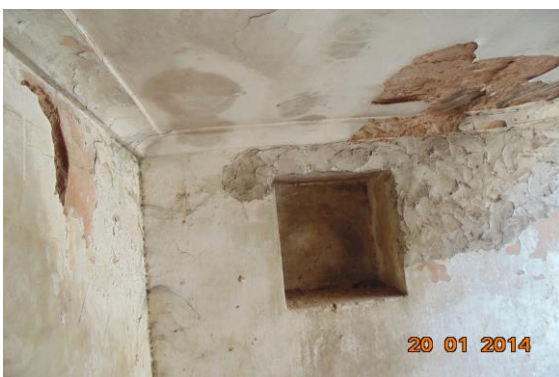
Photo 124

Peeling of Plaster on Wall No. 1, 3 & Roof of Passage 2 of First Floor, Tripoliya Gate of Room No. 5

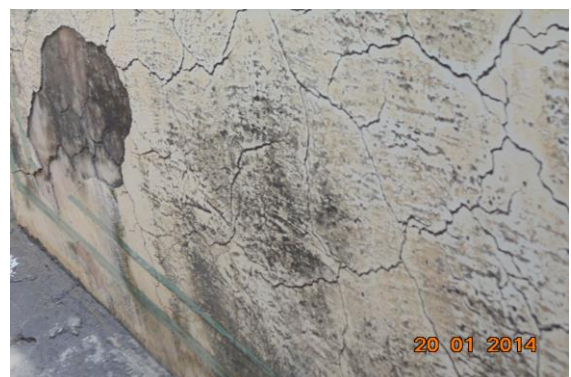
Photo 125

Peeling of Plaster on Wall No. 2 of Passage 2 of First Floor, Tripoliya Gate of Room No. 5

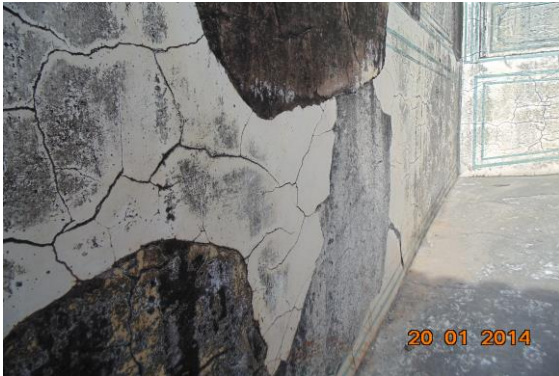
Photo 126

Peeling of Plaster on Wall No. 1 of Passage 2 of First Floor, Tripoliya Gate of Room No. 5

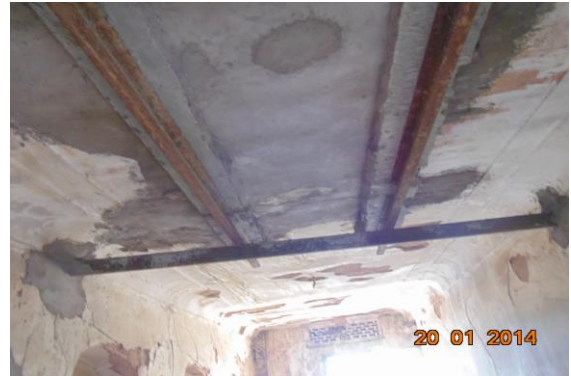
Photo 127

Peeling of Plaster on Roof of Passage 1 of First Floor, Tripoliya Gate of Room No. 5

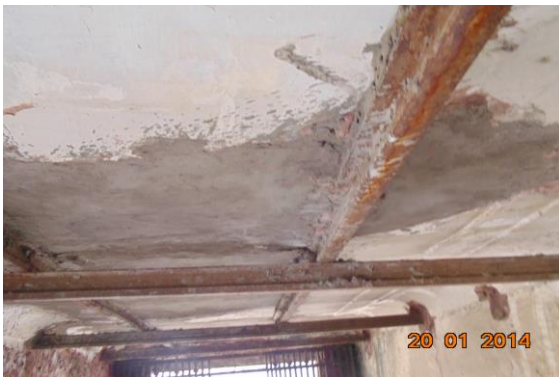
Photo 128

Peeling of Plaster on Roof of Passage 1 of First Floor, Tripoliya Gate of Room No. 5

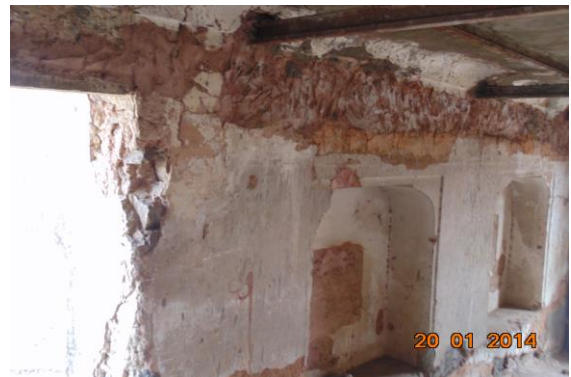
Photo 129

Damaged Portion on Wall No. 3 of Passage 1 of First Floor, Tripoliya Gate of Room No. 5

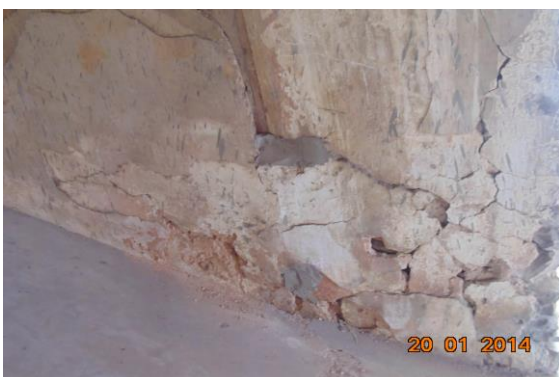
Photo 130

Damaged Portion on Wall No. 3 of Passage 1 of First Floor, Tripoliya Gate of Room No. 5

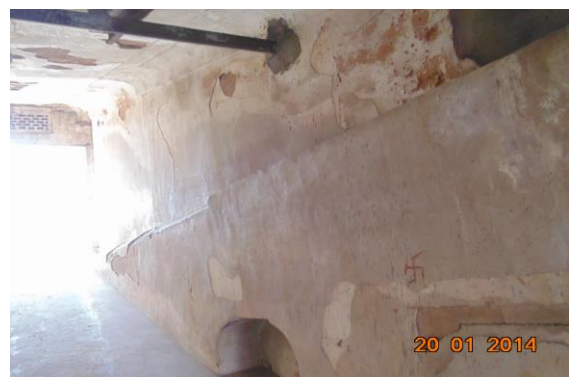
Photo 131

Damaged Portion on Wall No. 3 of Passage 1 of First Floor, Tripoliya Gate of Room No. 5

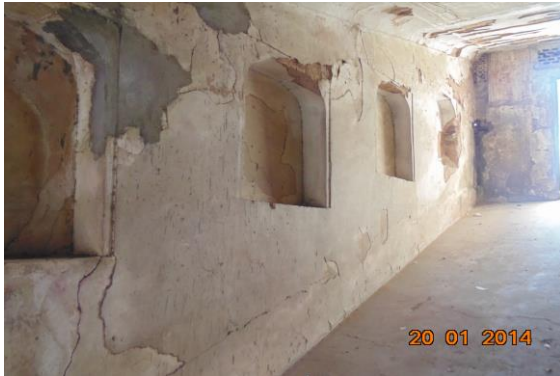
Photo 132

Peeling of Plaster on Wall No. 4 of Passage 1 of First Floor, Tripoliya Gate of Room No. 5

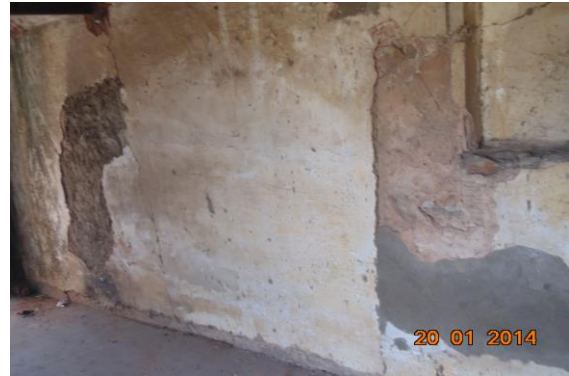
Photo 133

Peeling of Plaster on Wall No. 4 of Passage 1 of First Floor, Tripoliya Gate of Room No. 5

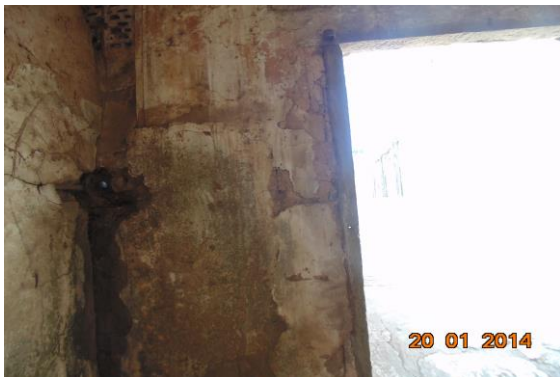
Photo 134

Peeling of Plaster on Wall No. 2 of Passage 1 of First Floor, Tripoliya Gate of Room No. 5

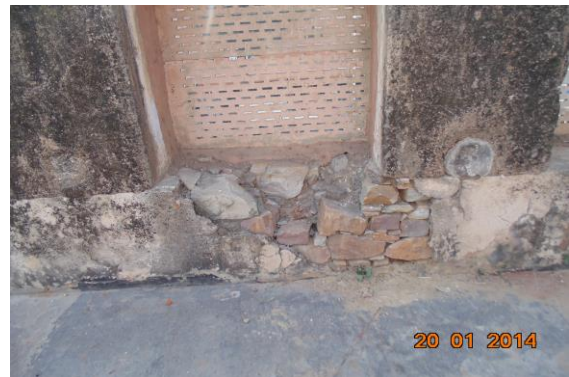
Photo 135

Peeling of Plaster on Wall No. 2 of Tripoliya Gate, Terrace

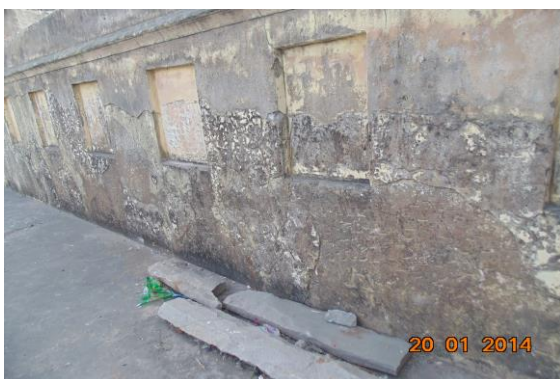
Photo 136

Peeling of Plaster on Wall No. 2 of Tripoliya Gate, Terrace

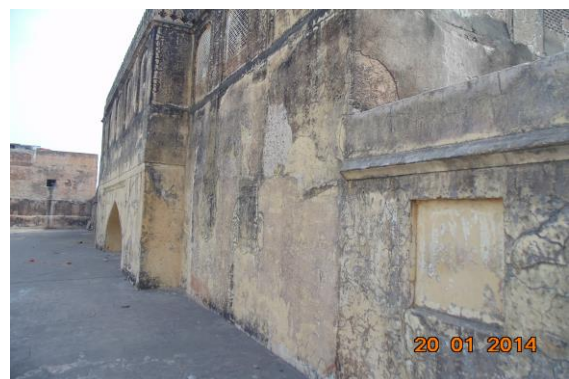
Photo 137

Peeling of Plaster on Wall No. 2 of Tripoliya Gate, Terrace

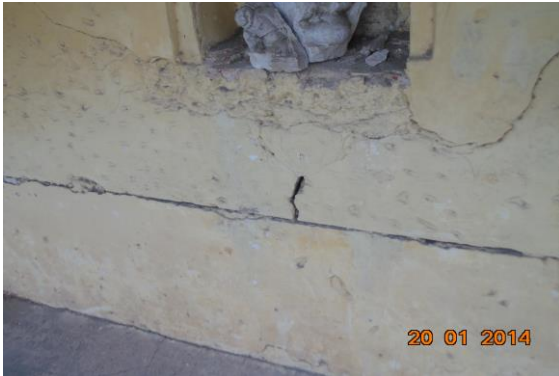
Photo 138
Peeling of Plaster on Wall No. 2 of Tripoliya Gate, Terrace

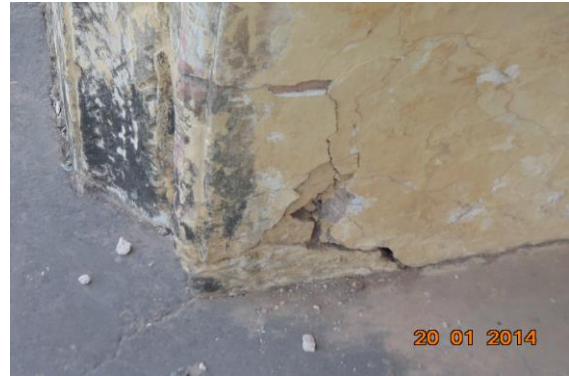
Photo 139
Peeling of Plaster on Wall No. 2 of Tripoliya Gate, Terrace

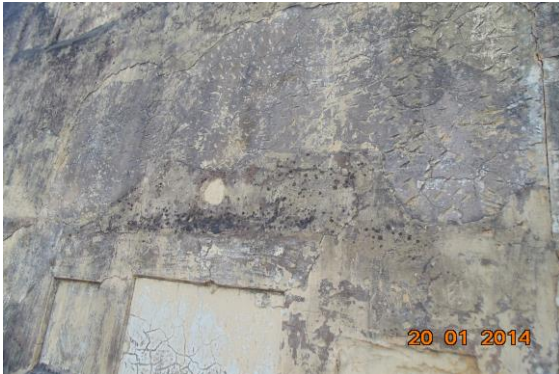
Photo 140
Peeling of Plaster on Wall No. 2 of Tripoliya Gate, Terrace

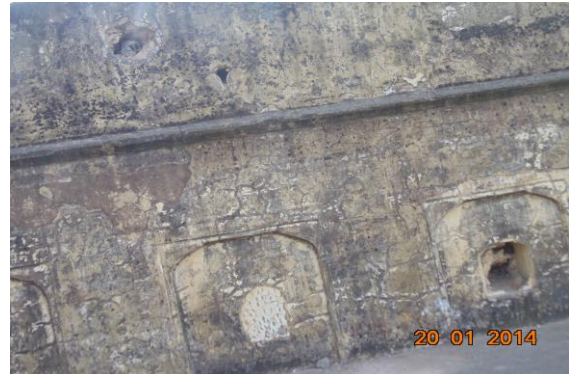
Photo 141
Peeling of Plaster on Wall No. 2 of Tripoliya Gate, Terrace

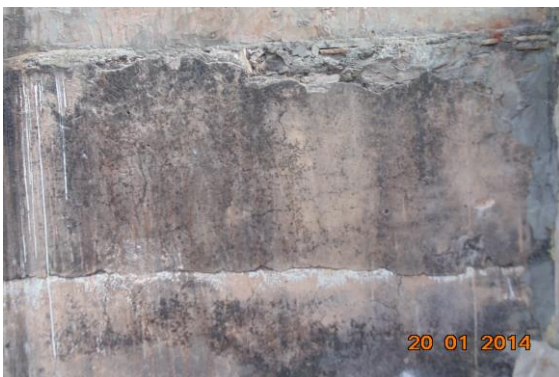
Photo 142
Peeling of Plaster on Wall No. 4 of Tripoliya Gate, Terrace

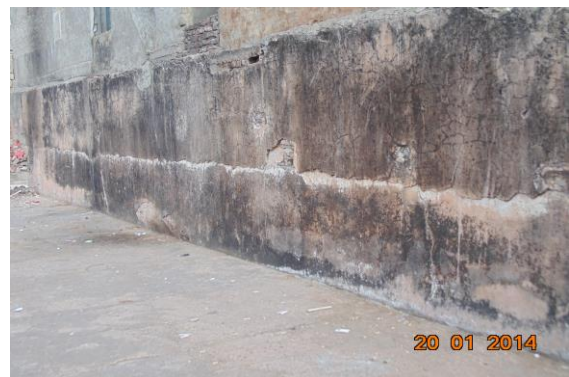
Photo 143
Peeling of Plaster on Wall No. 4 of Tripoliya Gate, Terrace

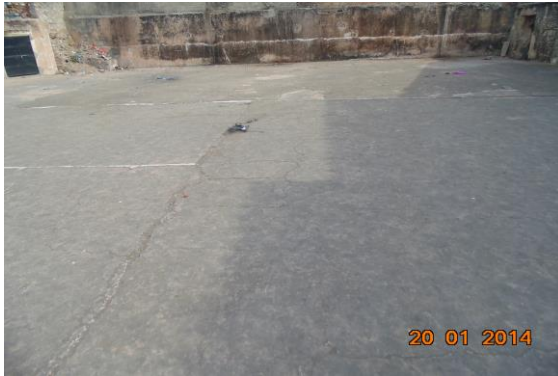
Photo 144
Peeling of Plaster on Floor of Tripoliya Gate, Terrace

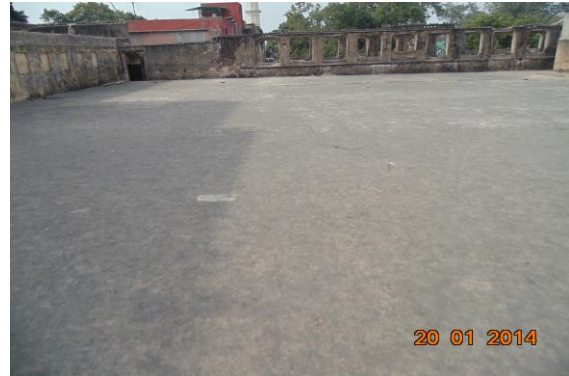
Photo 145
Peeling of Plaster on Floor of Tripoliya Gate, Terrace

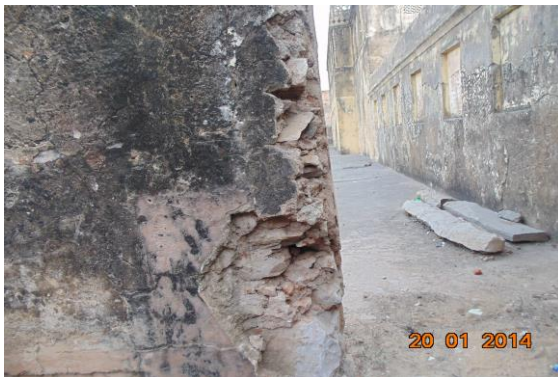
Photo 146
Peeling of Plaster on Wall No. 3 of Outer Wall of Tripoliya Gate, Terrace

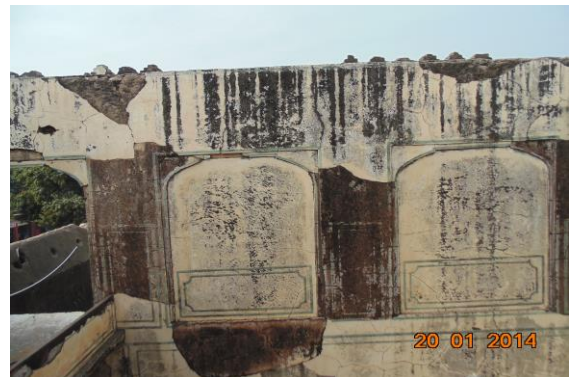
Photo 147
Peeling of Plaster on Wall No. 3 of Minarets of Tripoliya Gate, Terrace

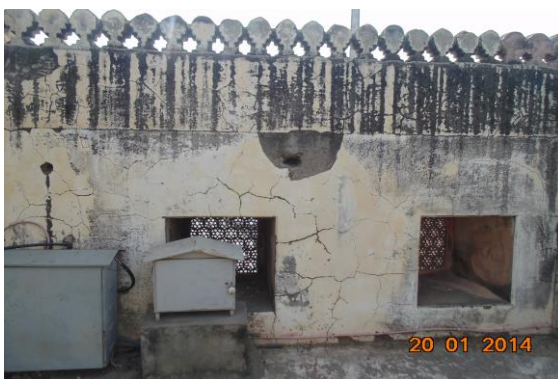
Photo 148
Peeling of Plaster on Wall No. 2 of Minarets of Tripoliya Gate, Terrace

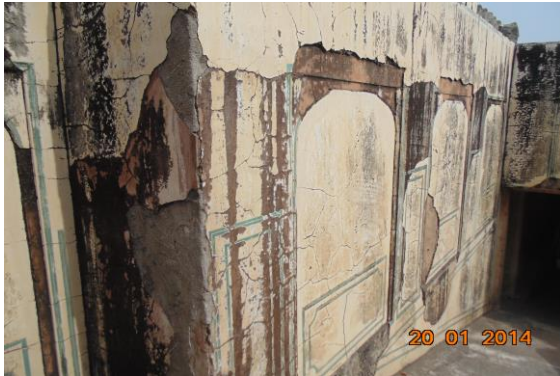
Photo 150

Peeling of Plaster on Wall No. 1 of Minarets of Tripoliya Gate, Terrace

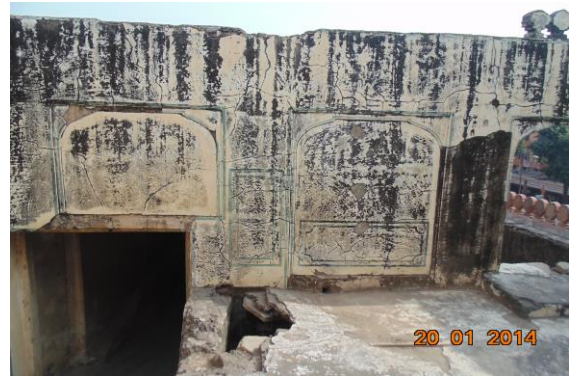
Photo 151

Peeling of Plaster on Wall No. 4 of Minarets of Tripoliya Gate, Terrace

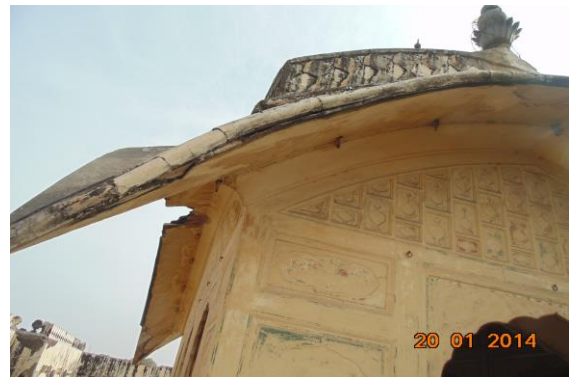
Photo 153

Damaged Portion on Wall No. 2 & Shade of Minarets of Tripoliya Gate, Terrace

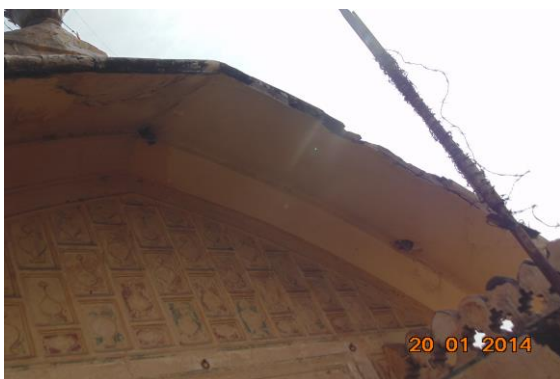
Photo 154

Damaged Portion on Wall No. 2 & Shade of Minarets of Tripoliya Gate, Terrace

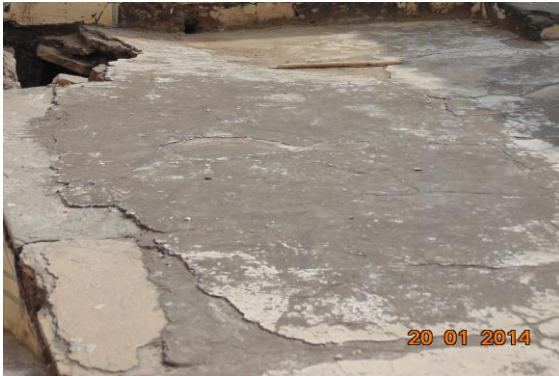
Photo 156

Damaged Portion on Terrace of Minarets of Tripoliya Gate, Terrace

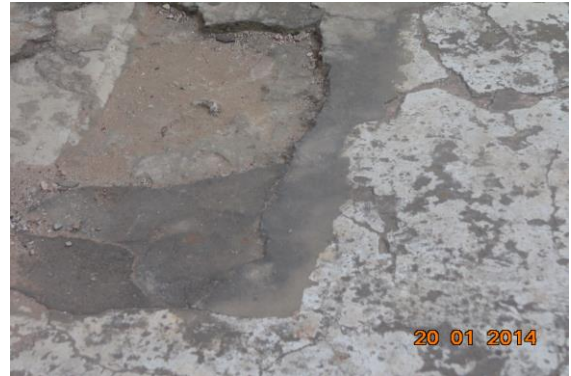
Photo 157

Damaged Portion on Terrace of Minarets of Tripoliya Gate, Terrace

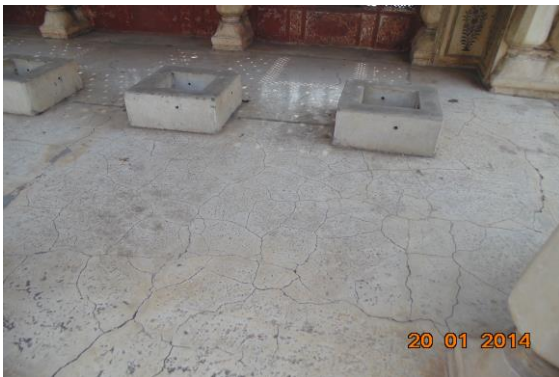
Photo 158

Plaster Crack on Floor of Minarets of Tripoliya Gate, Terrace

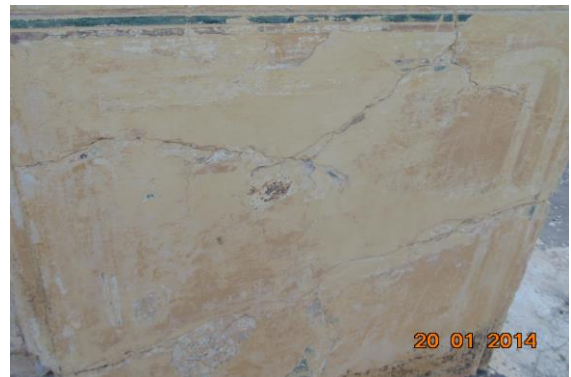
Photo 159

Plaster Crack on Wall No. 3 of Outer Wall of Tripoliya Gate, Terrace

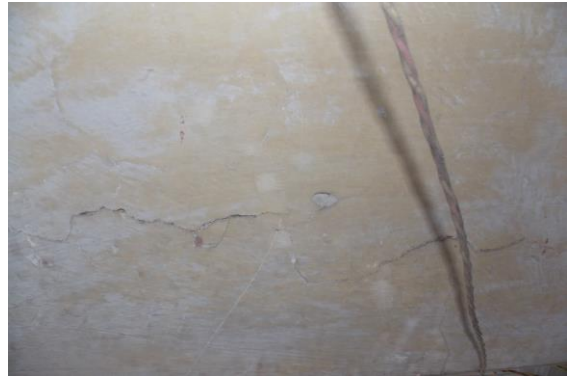
Photo 4
Horizontal Crack on Wall No. Roof & Gate of Temple Naval Bihari Ji, Ground Floor Approx. Width = 1mm, Approx. Length = 1.8m. Distance from Wall No.3 = 0.8m, Height from Floor = 2.2m.

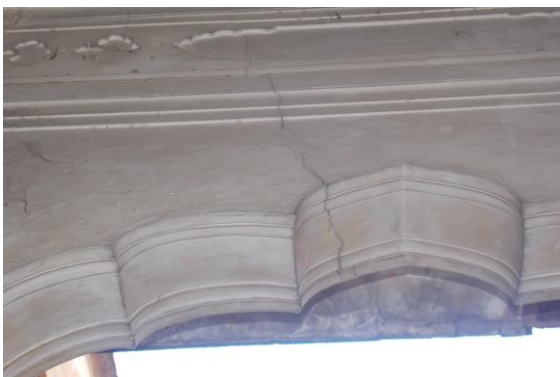
Photo 5
Inclined Crack on Wall No. 4 & Roof of Varanda No.1, Ground Floor Approx. Width = 3.5mm, Approx. Length = 6m. Distance from Wall No.1 = 1m, Height from Floor = 3.2m.

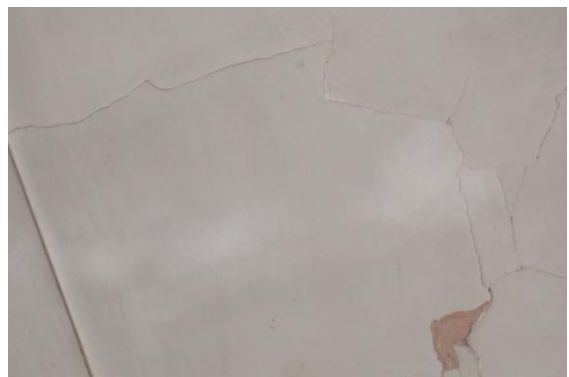
Photo 5A
Inclined Crack on Wall No. 4 & Roof of Varanda No.1, Ground Floor Approx. Width = 3.5mm, Approx. Length = 6m. Distance from Wall No.1 = 1m, Height from Floor = 3.2m.

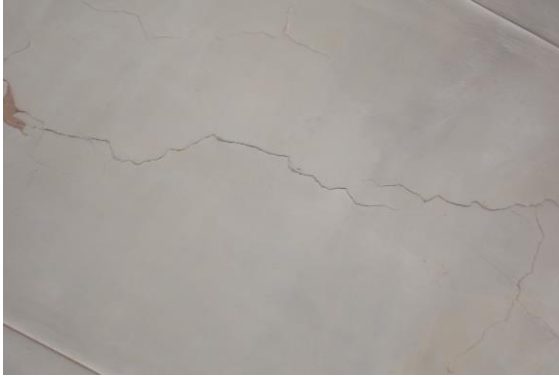
Photo 5A

Inclined Crack on Wall No. 4 & Roof of Varanda No.1, Ground Floor
Approx. Width = 3.5mm, Approx. Length = 6m. Distance from Wall No.1 = 1m, Height from Floor = 3.2m.

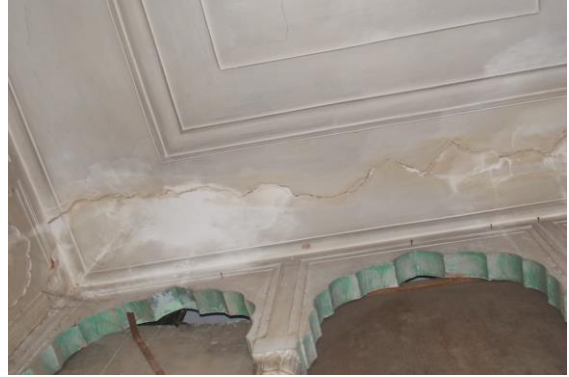
Photo 6

Inclined Crack on Wall No. 3, 4 & Roof of Varanda No.1, Ground Floor
Approx. Width = 4mm, Approx. Length = 3.5m. Distance from Wall No.1 = 0m, Height from Floor = 2.6m.

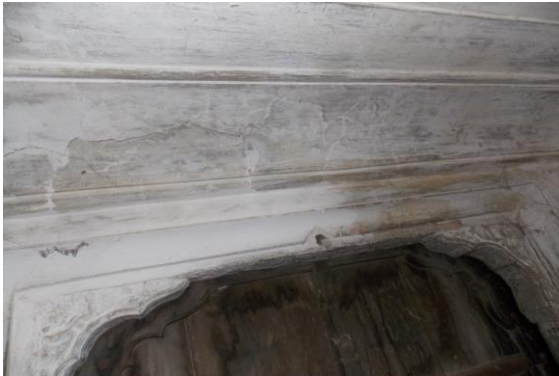
Photo 7

Inclined Crack on Wall No. Roof & 4 of Varanda No.1, Ground Floor
Approx. Width = 1mm, Approx. Length = 2m.
Distance from Wall No.1 = 0.8m, Height from Floor = 2m.

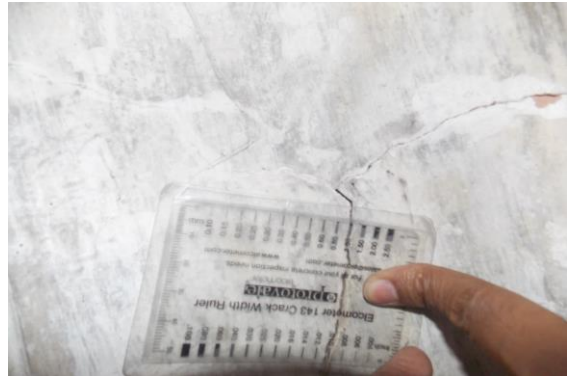
Photo 7A

Inclined Crack on Wall No. Roof & 4 of Varanda No.1, Ground Floor
Approx. Width = 1mm, Approx. Length = 2m.
Distance from Wall No.1 = 0.8m, Height from Floor = 2m.

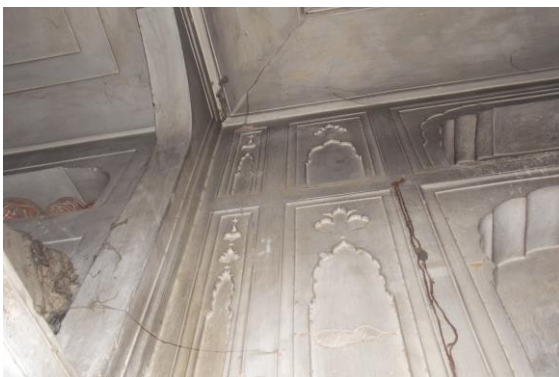
Photo 8

Inclined Crack on Wall No. 4 & Roof of Varanda No.5, Ground Floor
Approx. Width = 2mm, Approx. Length = 4m. Distance from Wall No.1 = 0.03m, Height from Floor = 1.9m.

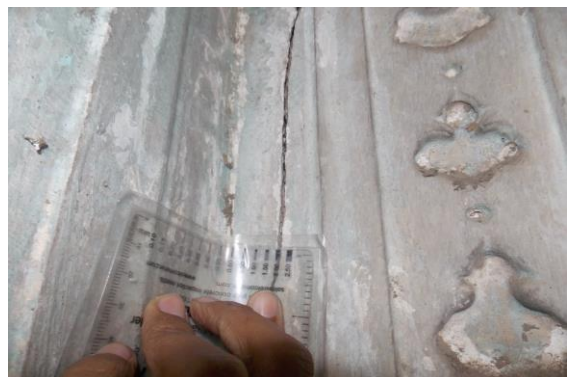
Photo 8A

Inclined Crack on Wall No. 4 & Roof of Varanda No.5, Ground Floor
Approx. Width = 2mm, Approx. Length = 4m. Distance from Wall No.1 = 0.03m, Height from Floor = 1.9m.

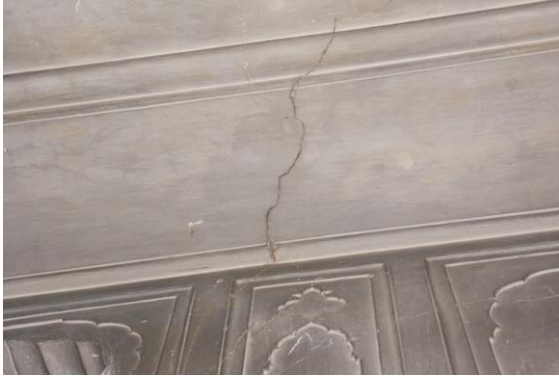
Photo 9

Inclined Crack on Wall No. 4 & Roof of Varanda No.5, Ground Floor
Approx. Width = 3.5mm, Approx. Length = 3.3m. Distance from Wall No.1 = 1.5m, Height from Floor = 2.8m.

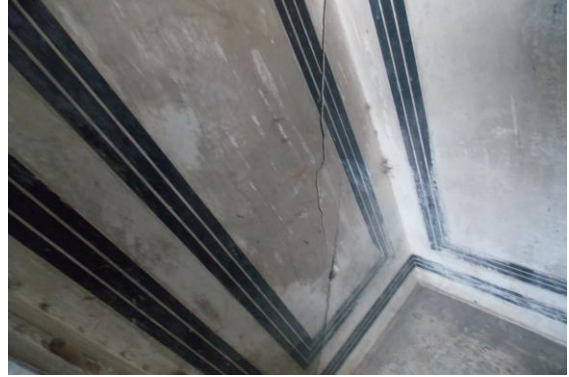
Photo 10

Inclined Crack on Wall No. 1 of Temple Naval Bihari Ji, Ground Floor
Approx. Width = 3.5mm, Approx. Length = 1.2m. Distance from Wall No.4 = 0.25m, Height from Floor = 0m.

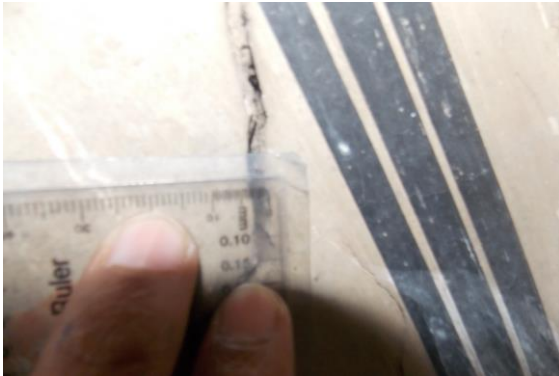
Photo 10A

Inclined Crack on Wall No. 1 of Temple Naval Bihari Ji, Ground Floor
Approx. Width = 3.5mm, Approx. Length = 1.2m. Distance from Wall No.4 = 0.25m, Height from Floor = 0m.

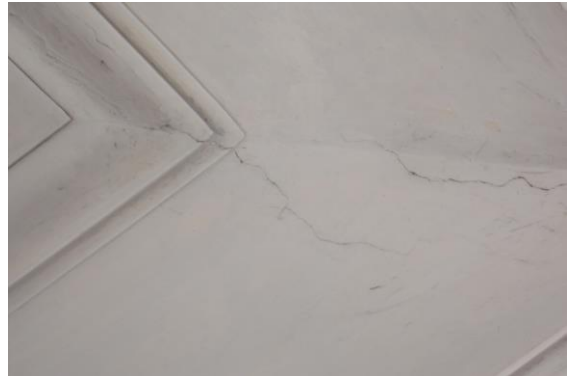
Photo 11

Inclined Crack on Roof of Temple Naval Bihari Ji, Ground Floor
Approx. Width = 2mm, Approx. Length = 4.8m.
Distance from Wall No.2 = 0.1m, Height from Floor = 3.5m.

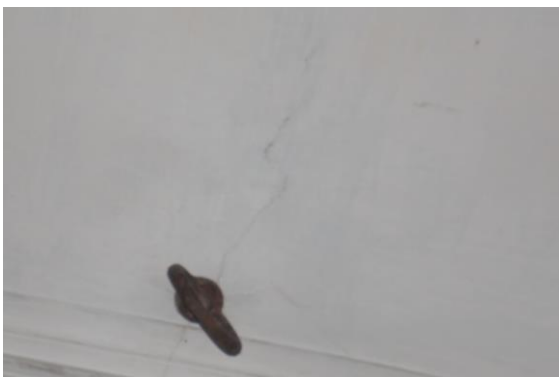
Photo 12

Inclined Crack on Roof of Temple Naval Bihari Ji, Ground Floor
Approx. Width = 2mm, Approx. Length = 3m.
Distance from Wall No.1 = 2.6m, Height from Floor = 3.8m.

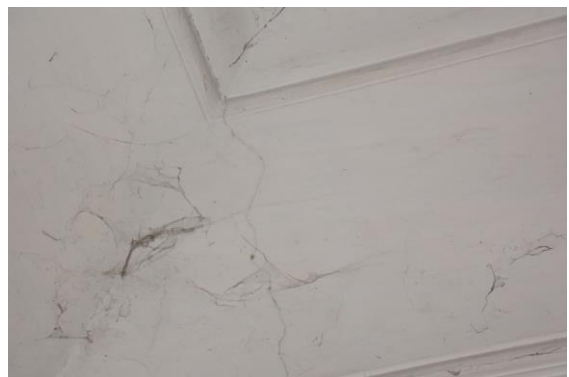
Photo 13

Inclined Crack on Roof of Temple Naval Bihari Ji, Ground Floor
Approx. Width = 0.35mm, Approx. Length = 5m.
Distance from Wall No.1 = 0.4m, Height from Floor = 3.5m.

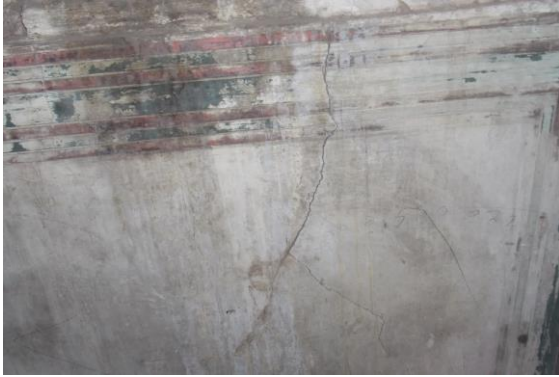
Photo 14

Inclined Crack on Wall No. 4 of Varanda No.6, Ground Floor
Approx. Width = 1mm, Approx. Length = 1.5m.
Distance from Wall No.2 = 0.15m, Height from Floor = 0m.

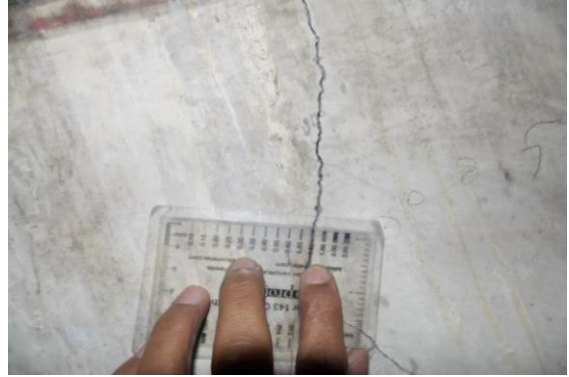
Photo 14A

Inclined Crack on Wall No. 4 of Varanda No.6, Ground Floor
Approx. Width = 1mm, Approx. Length = 1.5m.
Distance from Wall No.2 = 0.15m, Height from Floor = 0m.

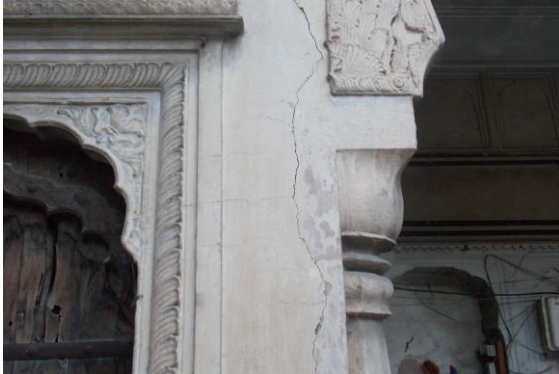
Photo 15

Inclined Crack on Wall No. 3 of Open Sky, Ground Floor
Approx. Width = 0.8mm, Approx. Length = 2m.
Distance from Wall No.2 = 1.5m, Height from Floor = 0.5m.

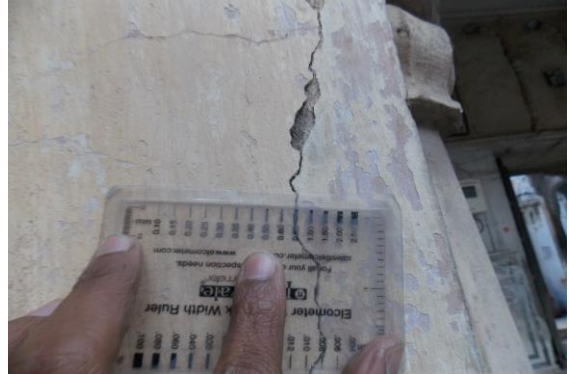
Photo 15A

Inclined Crack on Wall No. 3 of Open Sky, Ground Floor
Approx. Width = 0.8mm, Approx. Length = 2m.
Distance from Wall No.2 = 1.5m, Height from Floor = 0.5m.

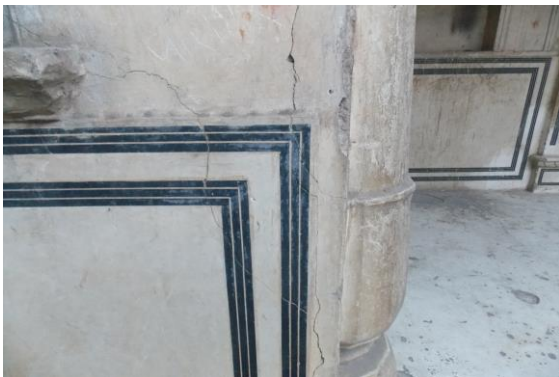
Photo 16

Inclined Crack on Wall No. 1 of Open Sky, Ground Floor
Approx. Width = 1.5mm, Approx. Length = 2.5m.
Distance from Wall No.4 = 1.5m, Height from Floor = 0.5m.

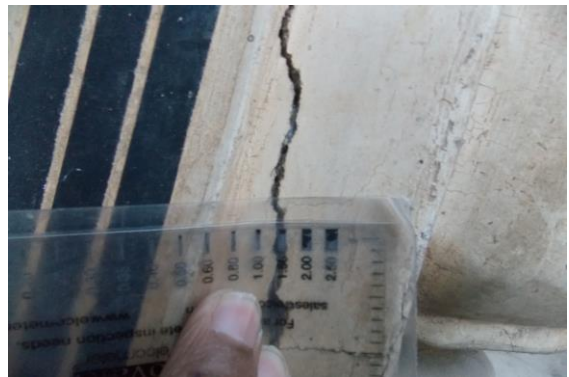
Photo 16A

Inclined Crack on Wall No. 1 of Open Sky, Ground Floor
Approx. Width = 1.5mm, Approx. Length = 2.5m.
Distance from Wall No.4 = 1.5m, Height from Floor = 0.5m.

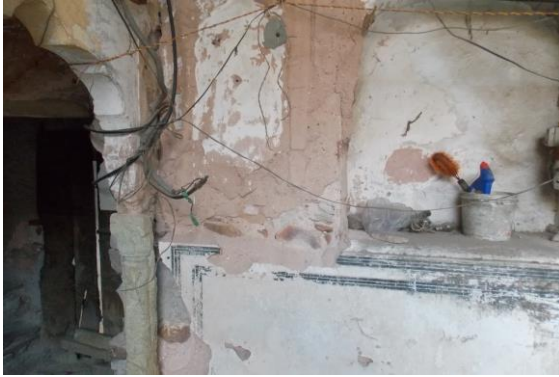
Photo 17

Damaged Portion on Wall No. 3 of Varanda No.1 of Ground Floor

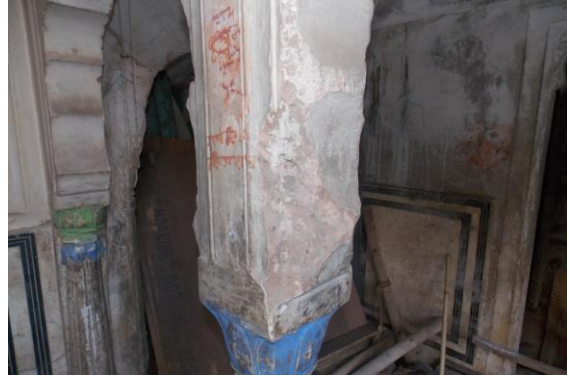
Photo 18

Peeling of Plaster on Wall No. 1 of Varanda No.1 of Ground Floor

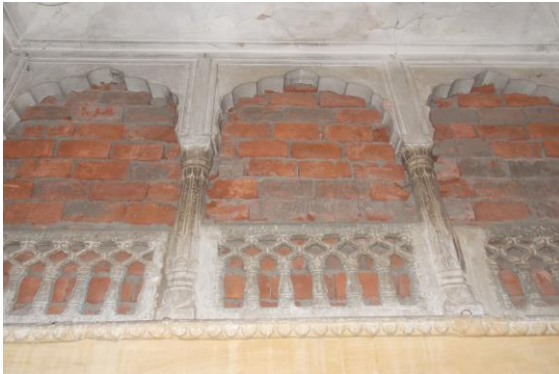
Photo 19

Peeling of Plaster on Wall No. 2 of Varanda No.1 of Ground Floor

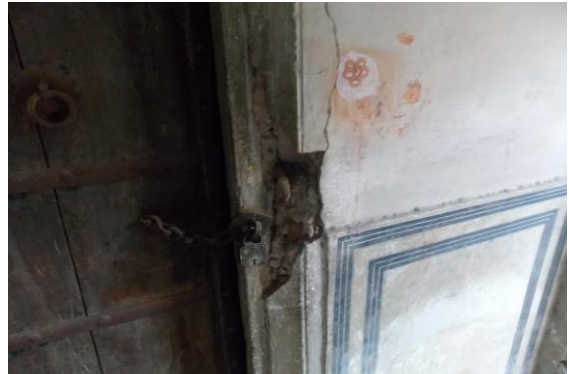
Photo 20

Damaged Portion on Wall No. 4 of Varanda No.1 of Ground Floor

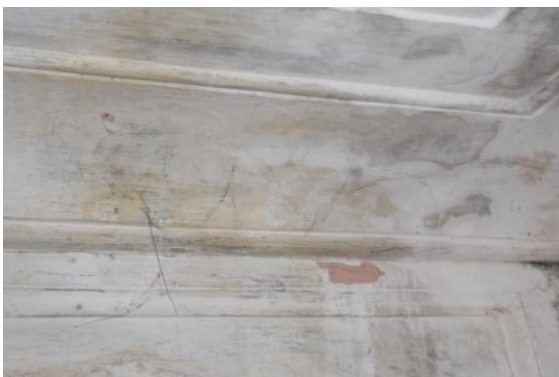
Photo 21

Peeling of Plaster on Wall No. 1 & Roof of Varanda No.1 of Ground Floor

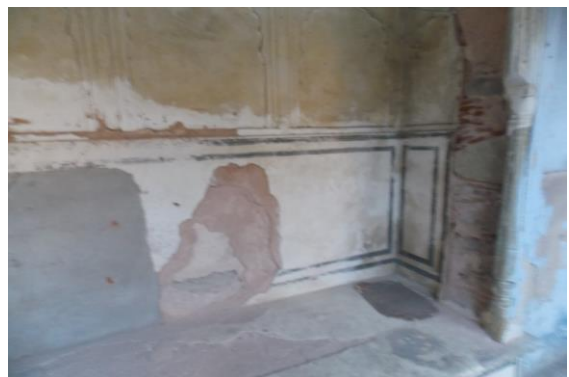
Photo 22

Damaged Portion on Wall No. 4 of Varanda No.3 of Ground Floor

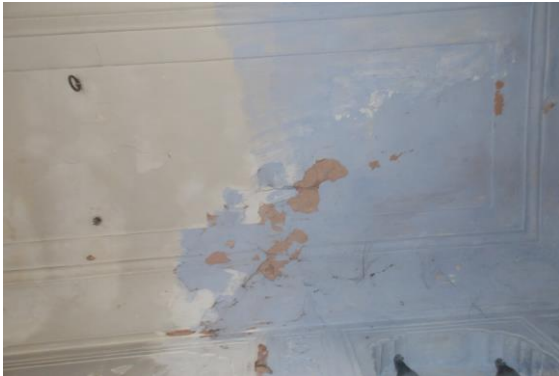
Photo 23
Peeling of Plaster on Roof of Varanda No.3 of Ground Floor

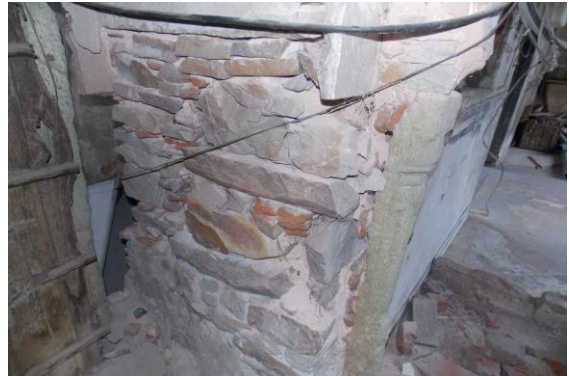
Photo 24
Damaged Portion on Wall No. 3 of Varanda No.4 of Ground Floor

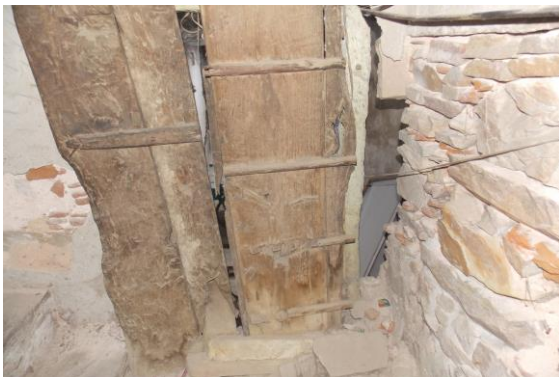
Photo 25
Damaged Portion on Wall No. 2 of Varanda No.4 of Ground Floor

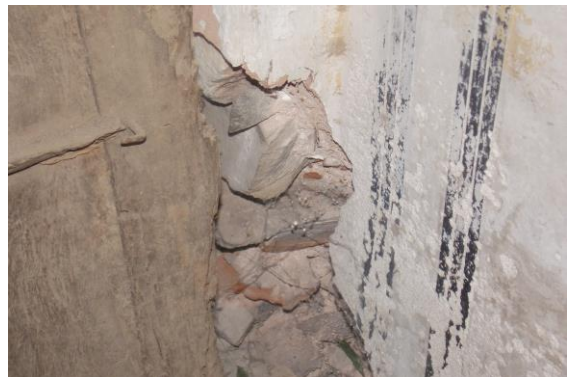
Photo 26
Damaged Portion on Wall No. 1 of Varanda No.4 of Ground Floor
