Pre Building Condition Survey Report

Name and Address of Structure :	Choti Chopar to Badi Chopar (UP Line)
---------------------------------	---------------------------------------

Name of the Project	Contract JMRC-UG1B “Design and Construction of Tunnel between Chandpole and Badi Chouper and reverse line by Shield TBM, Underground Metro Stations at Choti Chouper and Badi Chouper by Cut and Cover Methods on East West Corridor of Jaipur Metro Rail Corporation Limited .”	
Owner :

Shoping Complex - Shop No. 169-188
Tripolia Bazar
Jaipur
Unique ID: CC BC UP 0001

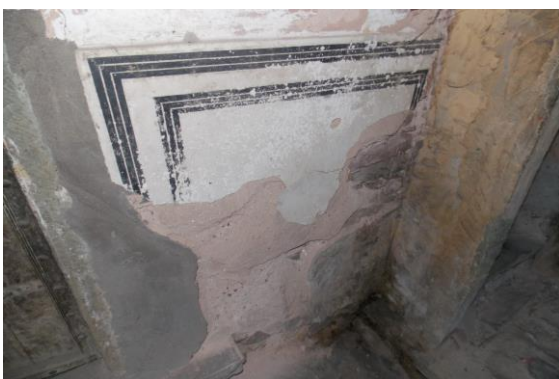
Photo 27
Damaged Portion on Wall No. 4 of Varanda No.4 of Ground Floor

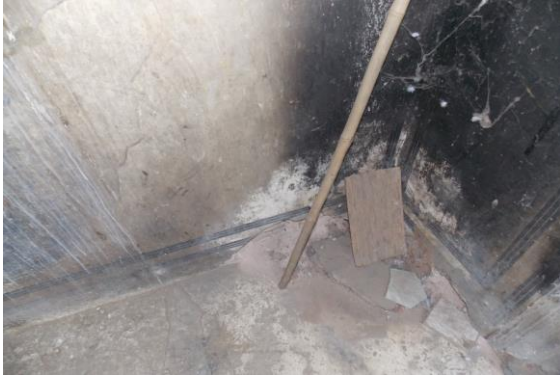
Photo 29

Damaged Portion on Wall No. 4 of Varanda No.5 of Ground Floor

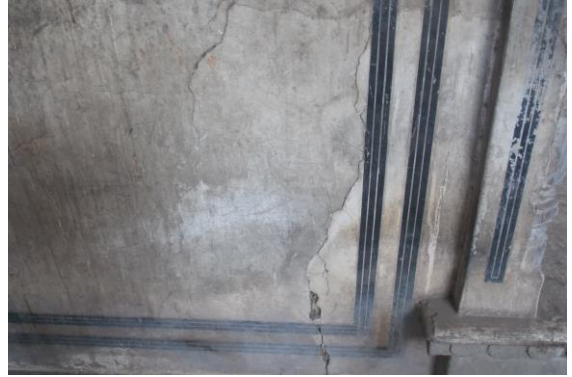
Photo 30

Damaged Portion on Wall No. 4 of Varanda No.5 of Ground Floor

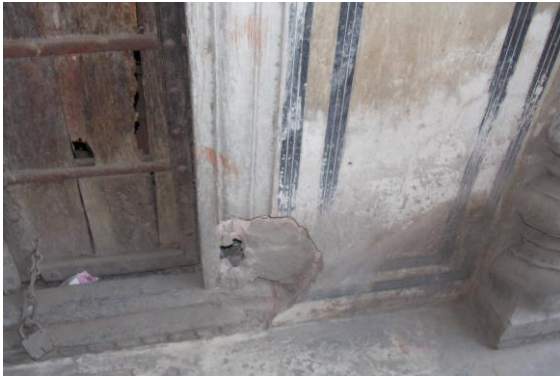
Photo 31

Damaged Portion on Wall No. 2 of Varanda No.5 of Ground Floor

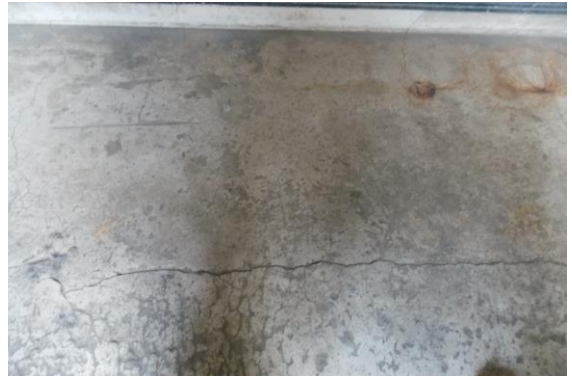
Photo 32

Peeling of Plaster on Floor of Toilet No. 2 of Ground Floor

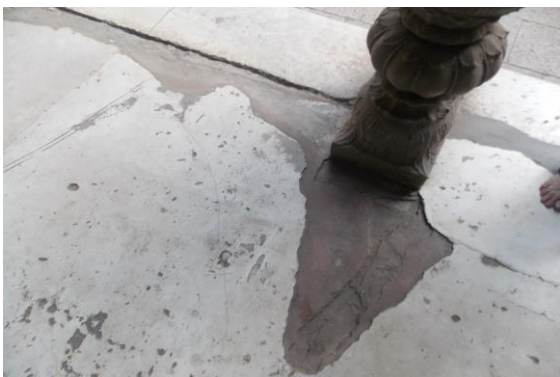
Photo 33

Peeling of Plaster on Floor of Varanda No.7 of Ground Floor

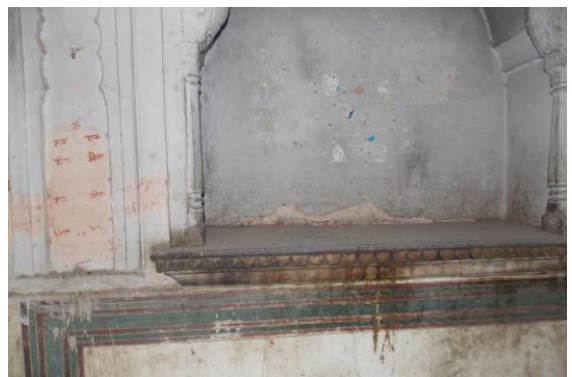
Photo 34

Peeling of Plaster on Wall No. 4 of Temple Naval Bihari Ji of Ground Floor

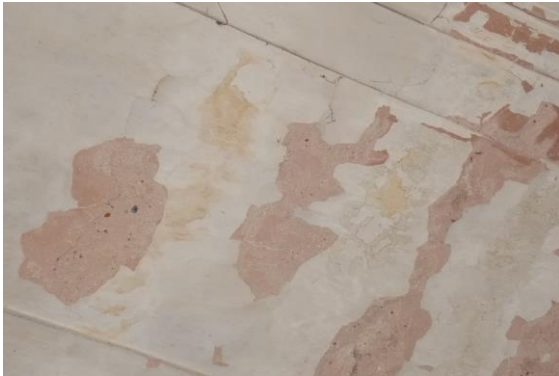
Photo 35

Peeling of Plaster on Roof of Temple Naval Bihari Ji of Ground Floor

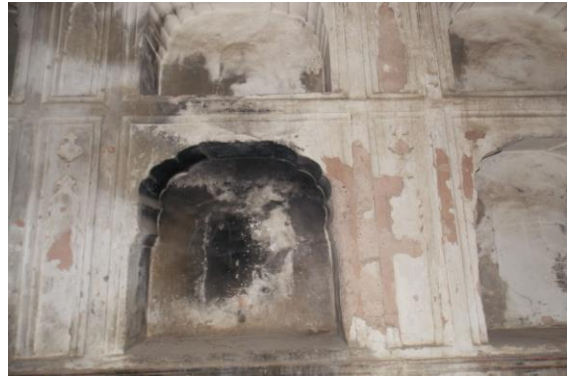
Photo 36

Peeling of Plaster on Wall No. 4 & Roof of Varanda No.6 of Ground Floor

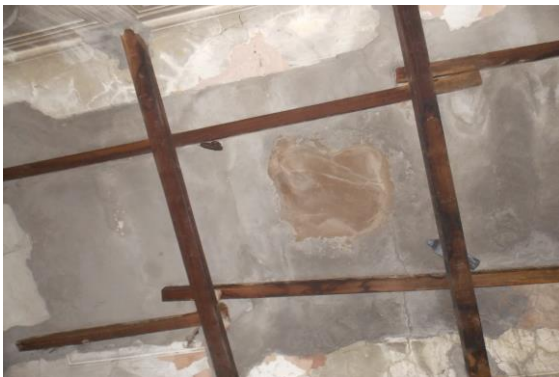
Photo 37

Damaged Portion on Roof of Varanda No.6 of Ground Floor

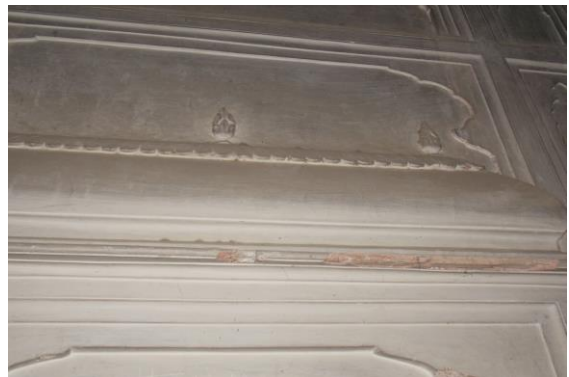
Photo 38

Damaged Portion on Wall No. 1 of Varanda No.6 of Ground Floor

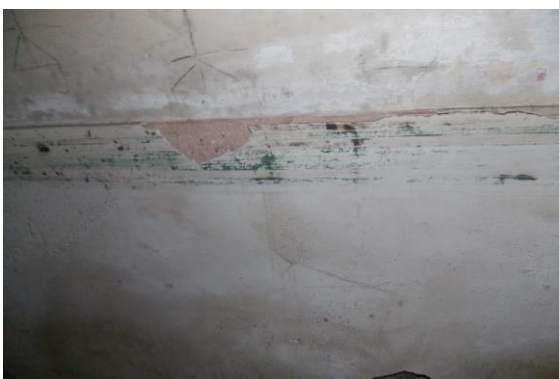
Photo 39

Peeling of Plaster on Wall No. 7 of Passage of Ground Floor

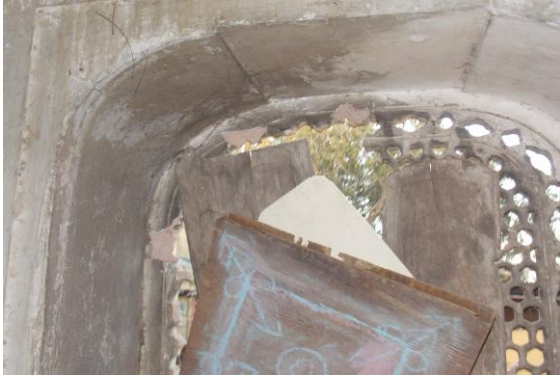
Photo 41
Damaged Portion on Wall No. 4 of Passage of Ground Floor

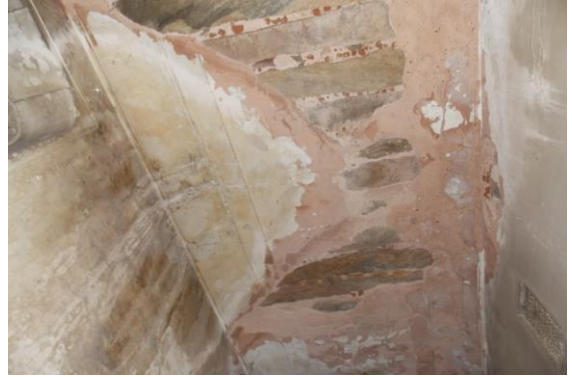
Photo 42
Damaged Portion on Roof of Passage of Ground Floor

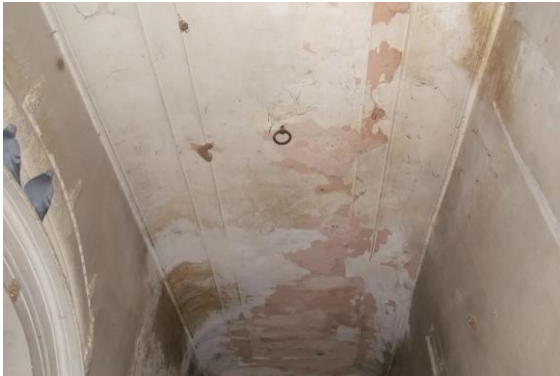
Photo 43
Damaged Portion on Roof of Passage of Ground Floor

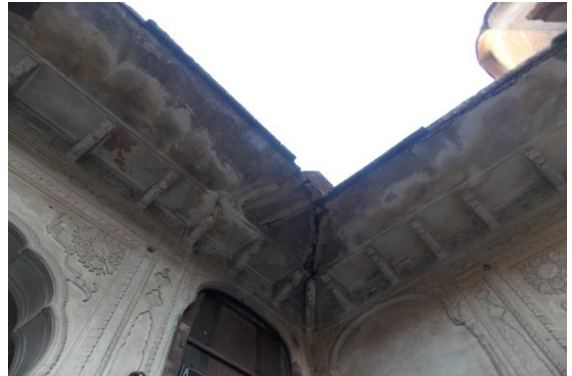
Photo 44
Damaged Portion on Sun Shade of Open Sky of Ground Floor

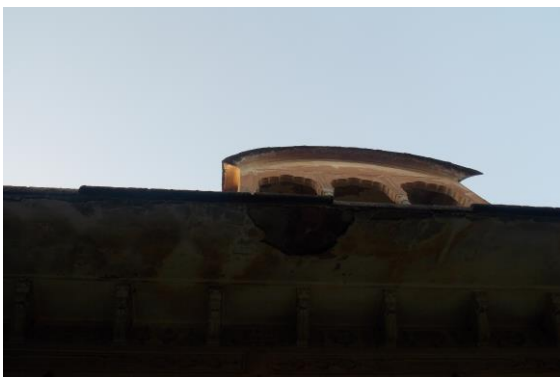
Photo 45
Damaged Portion on Sun Shade of Open Sky of Ground Floor

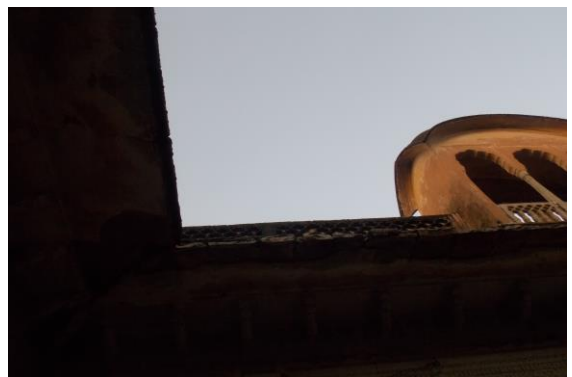
Photo 46
Damaged Portion on Sun Shade of Open Sky of Ground Floor

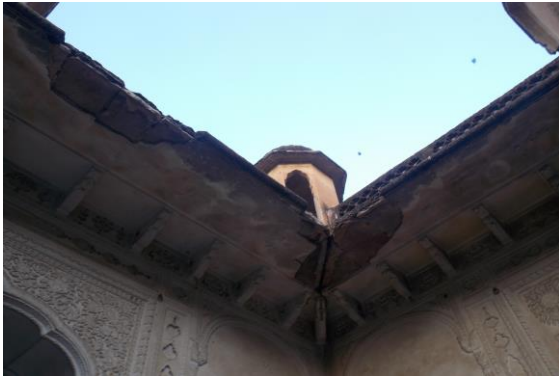
Photo 47

Damaged Portion on Sun Shade of Open Sky of Ground Floor

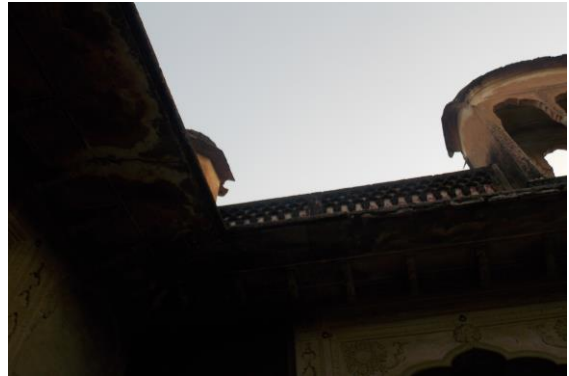
Photo 48

Damaged Portion on Sun Shade of Open Sky of Ground Floor

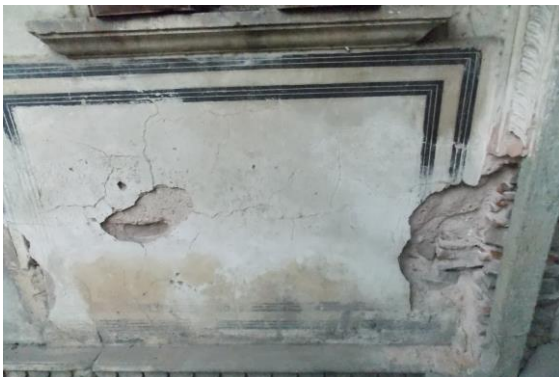
Photo 49

Damaged Portion on Wall No. 2 of Open Sky of Ground Floor

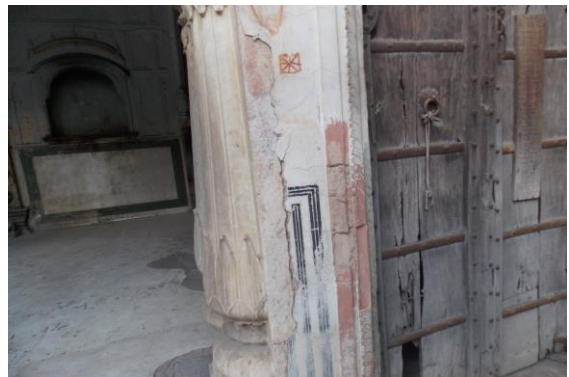
Photo 50

Peeling of Plaster on Wall No. 4 of Open Sky of Ground Floor

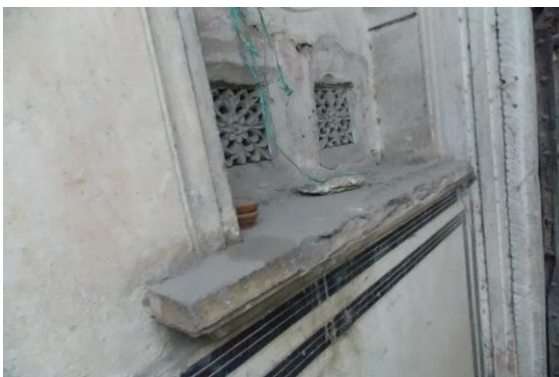
Photo 51

Peeling of Plaster on Wall No. 1 of Open Sky of Ground Floor

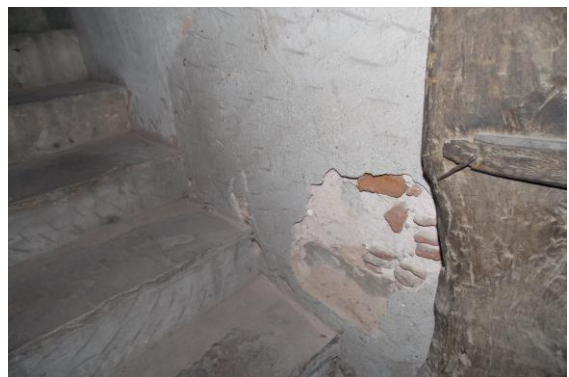
Photo 52

Damaged Portion on Wall No. 2 of StairCase No.2 of Ground Floor

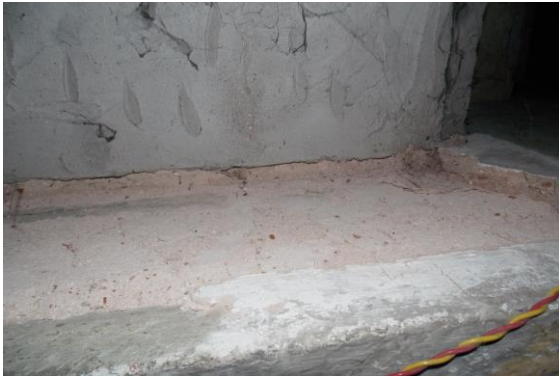
Photo 53

Peeling of Plaster on Wall No. 1 of StairCase No.1 of Ground Floor

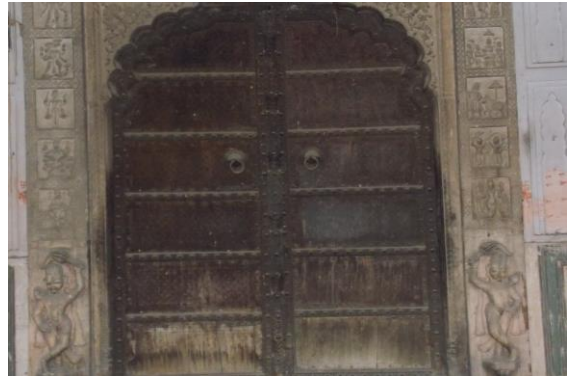
Photo 54

Damaged Portion on Sun shade & Main gate of Temple Naval Bihari Ji of Ground Floor

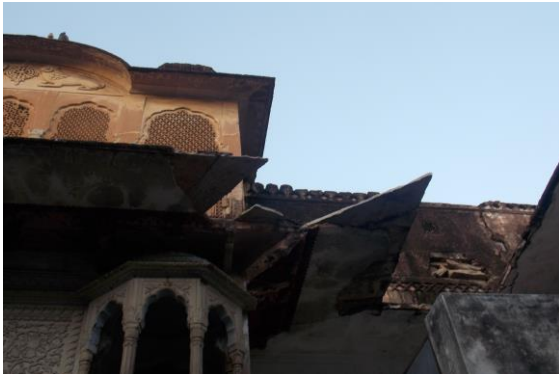
Photo 55

Damaged Portion on Frontside wall of Temple Naval Bihari Ji of Ground Floor

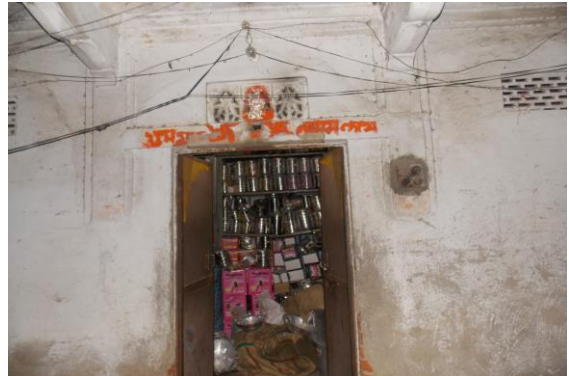
Photo 2
View of Godown No.1, Ground Floor

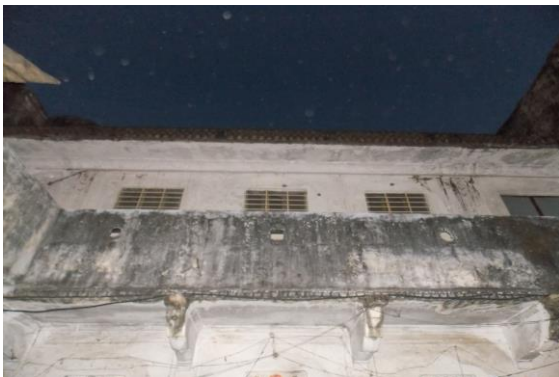
Photo 3
View of Navleshwar Temple, First floor

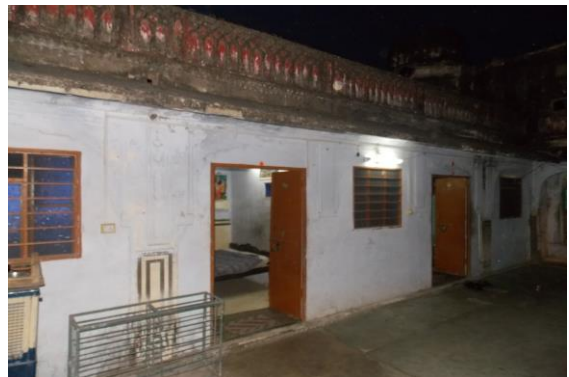
Photo 4
View of Navleshwar Temple, First floor

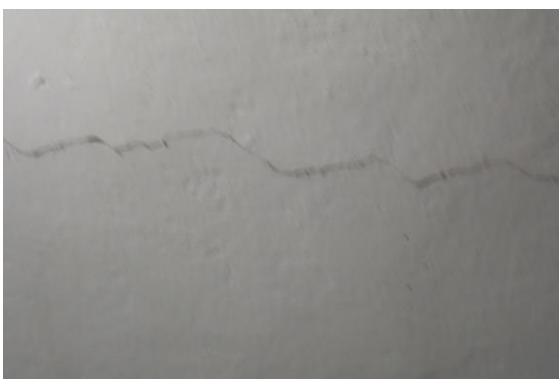
Photo 5
Inclined Crack on Roof of Kitchen, Ground Floor
Approx. Width = 0.35mm, Approx. Length = 1.7m.
Distance from Wall no.3 = 0m, Height from Floor = 3m.

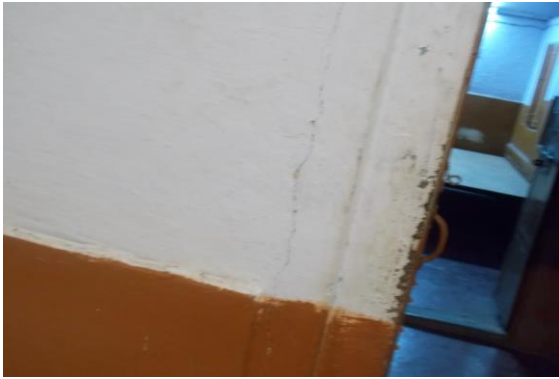
Photo 7

Vertical Crack on Wall No. 3 of Kitchen,
Approx. Width = 0.35mm, Approx. Length = 1m.
Distance from Wall No.2 = 0.92m, Height from Floor = 0.86m.

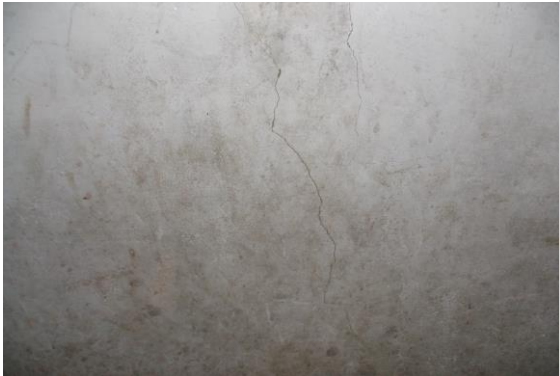
Photo 8

Inclined Crack on Wall No. 4 of Bathroom No. , Navleshwar Temple,
First floor Approx. Width = 0.35mm, Approx. Length = 1.3m. Distance
from Wall No.1 = 1.3m, Height from Floor = 1m.

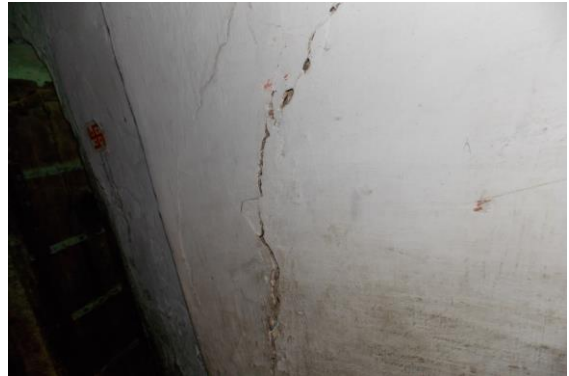
Photo 9

Inclined Crack on Wall No. 2 of Passage, First floor
Approx. Width = 5mm, Approx. Length = 1.7m.
Distance from Wall No.4 = 1.3m, Height from Floor = 0.8m.

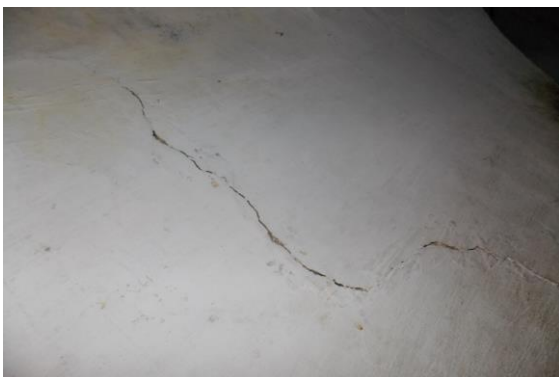
Photo 10

Inclined Crack on Wall No. 1 of Passage, First floor
Approx. Width = 3mm, Approx. Length = 1.7m.
Distance from Wall No.4 = 1.3m, Height from Floor = 0.8m.

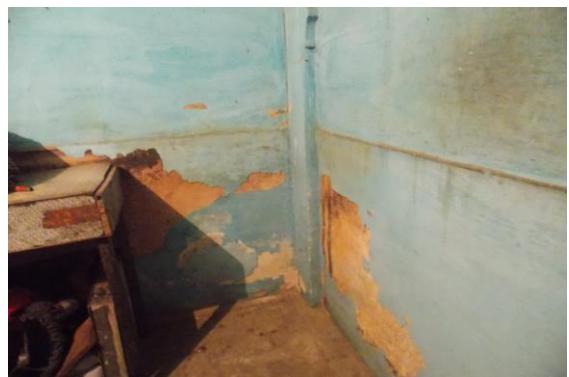
Photo 11

Peeling of Plaster on Wall No. 2 & 4 of Room No. 1 of Navleshwar
Temple, Ground Floor

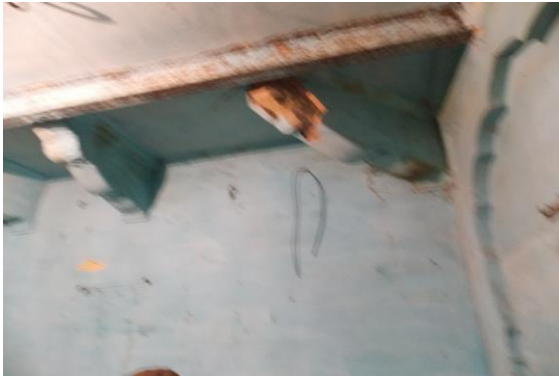
Photo 12
Damaged Portion on Roof of Room No. 1 of Navleshwar Temple,
Ground Floor

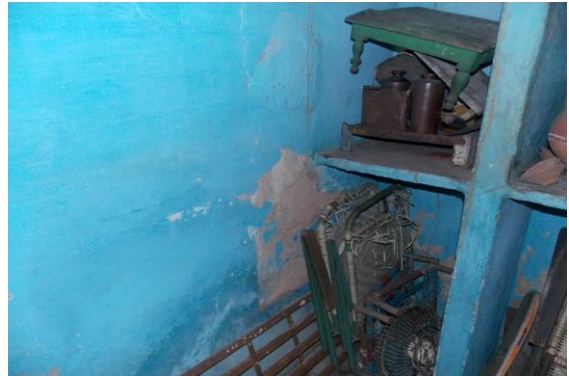
Photo 13
Damaged Portion on Wall No. 3 of Room No. 1 of Navleshwar Temple,
Ground Floor

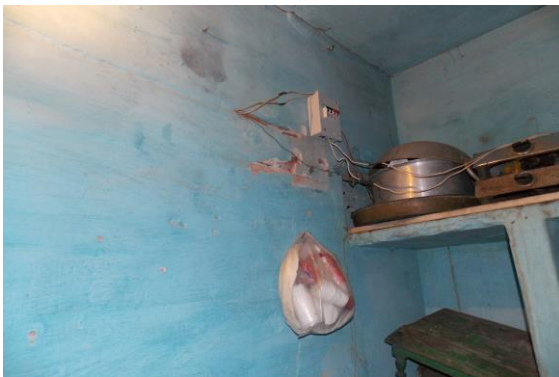
Photo 14
Damaged Portion on Wall No. 3 of Room No. 1 of Navleshwar Temple,
Ground Floor

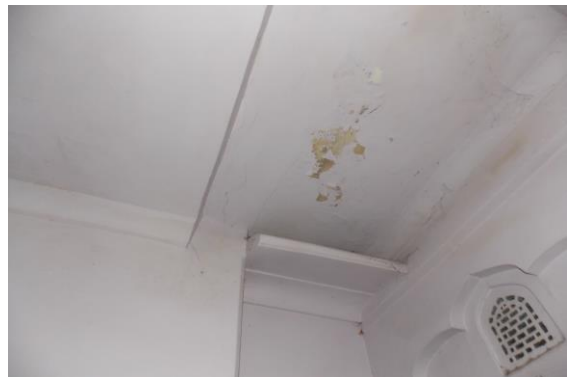
Photo 15
Plaster Crack on Roof of Room No. 3 of Navleshwar Temple, Ground
Floor

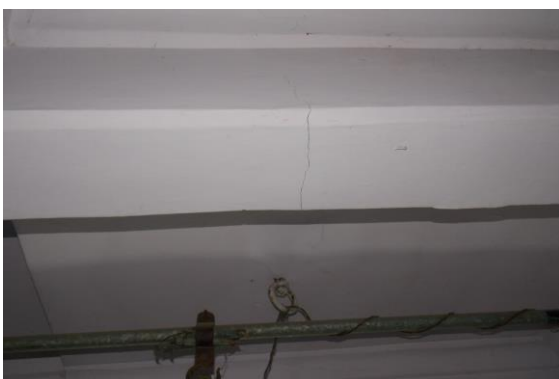
Photo 16
Plaster Crack on Roof & Beam of Room No. 3 of Navleshwar Temple,
Ground Floor

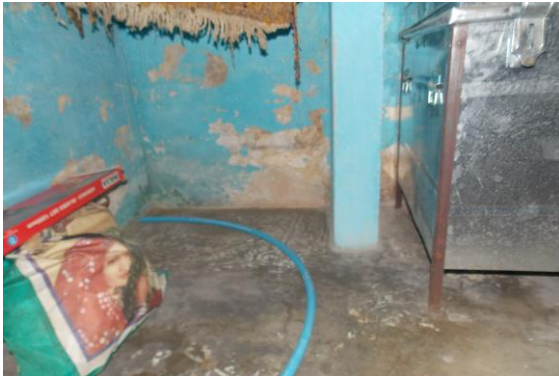
Photo 18

Peeling of Plaster on Wall No. 4 of Room No. 4 of Navleshwar Temple, Ground Floor

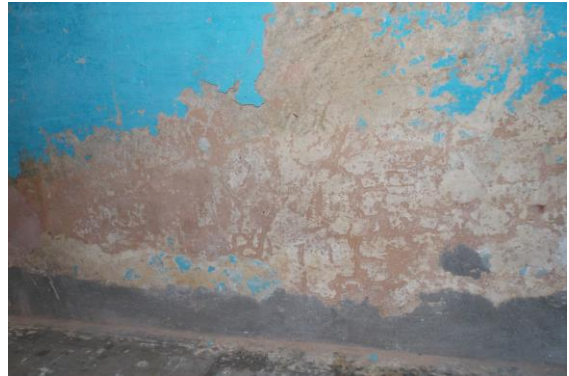
Photo 19

Dampness/Seepage on Wall No. 2 of Room No. 4 of Navleshwar Temple, Ground Floor

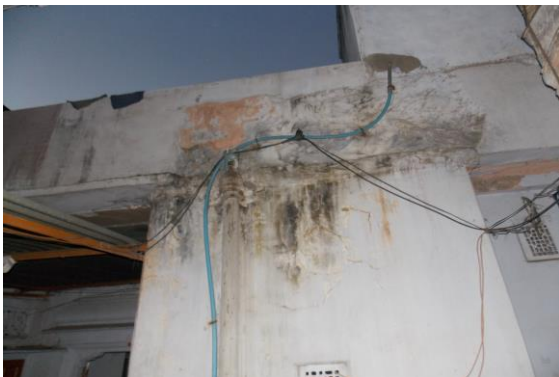
Photo 20

Peeling of Plaster on External Wall of Navleshwar Temple of Ground Floor

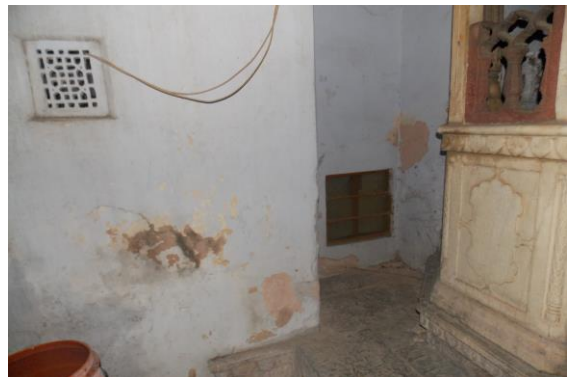
Photo 21

Peeling of Plaster on External Wall of Navleshwar Temple of Ground Floor

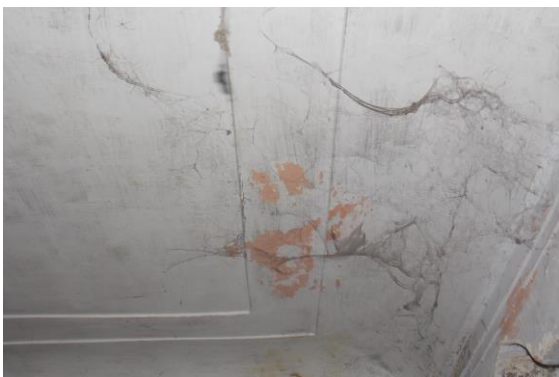
Photo 22

Peeling of Plaster on Roof of Room No. 1 of Godown No.1, Ground Floor

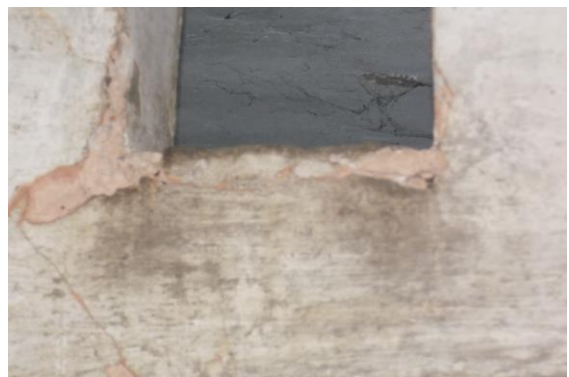
Photo 23

Peeling of Plaster on Wall No. 2 of Room No. 1 of Godown No.1, Ground Floor

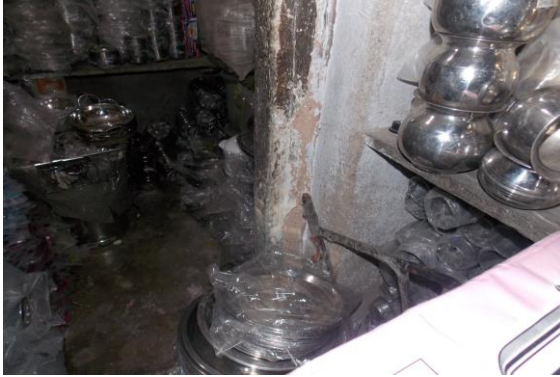
Photo 24

Peeling of Plaster on Wall No. 1 of Room No. 1 of Godown No.1,
Ground Floor

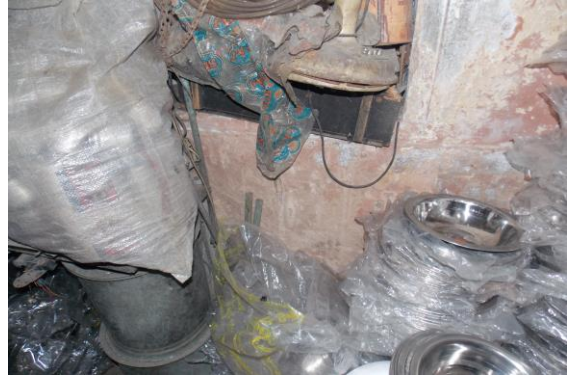
Photo 25

Peeling of Plaster on Wall No. 2 of Room No. 2 of Godown No.1,
Ground Floor

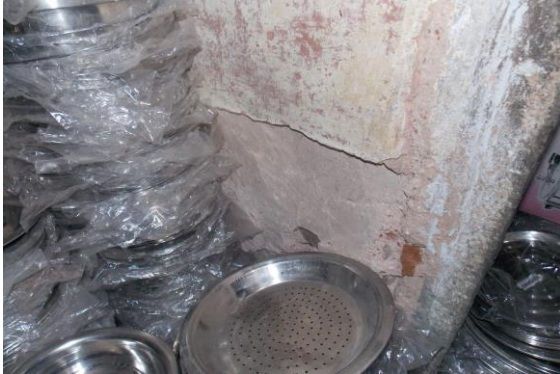
Photo 26

Peeling of Plaster on Wall No. 3 of Room No. 2 of Godown No.1,
Ground Floor

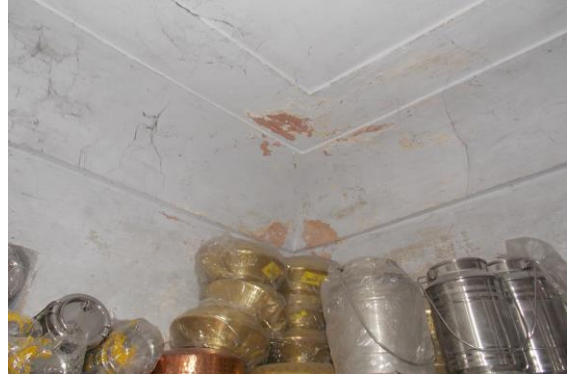
Photo 27

Peeling of Plaster on Roof of Room No. 2 of Godown No.1, Ground
Floor

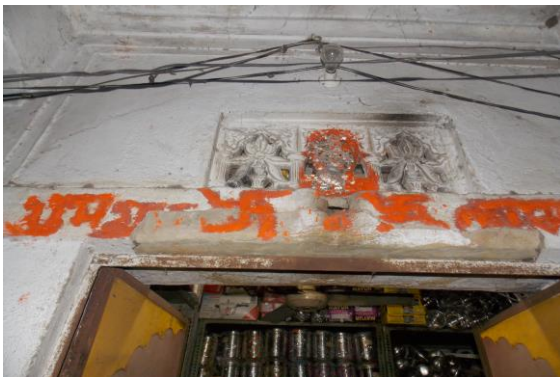
Photo 28

Damaged Portion on External Beam of Godown No.1 of Ground Floor

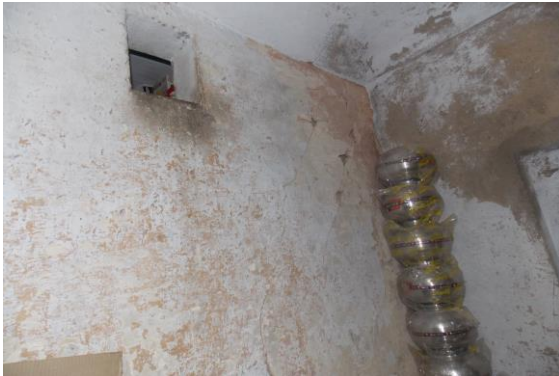
Photo 30

Damaged Portion on Wall No. 1 & 2 of Godown No.1 of Ground Floor

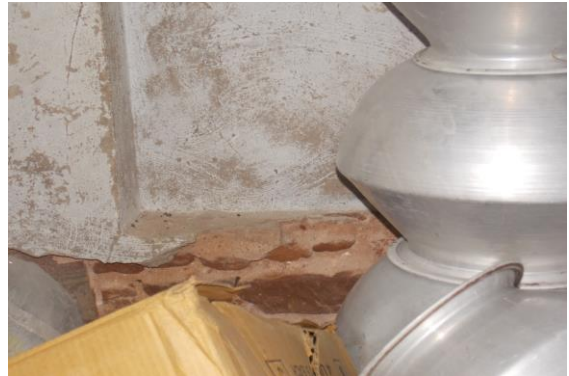
Photo 31

Damaged Portion on Wall No. 4 of Godown No.1 of Ground Floor

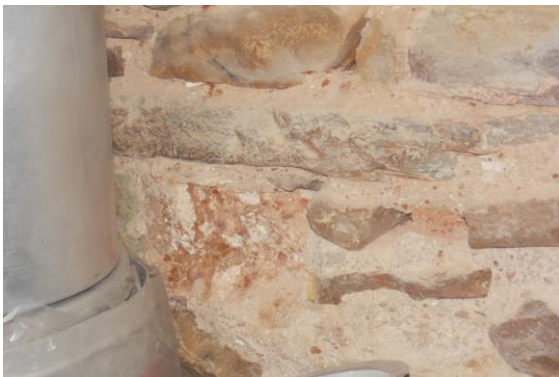
Photo 32

Damaged Portion on Wall No. 2 of Godown No.1 of Ground Floor

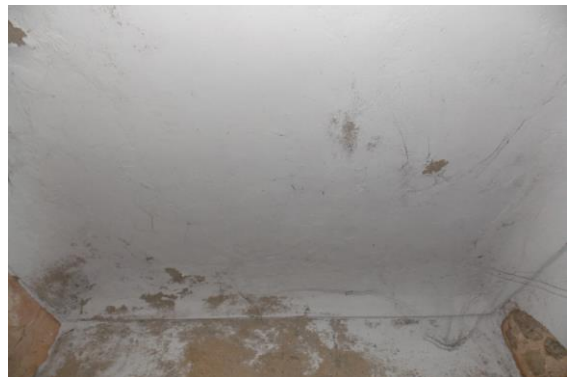
Photo 33

Peeling of Plaster on Roof of Godown No.1 of Ground Floor

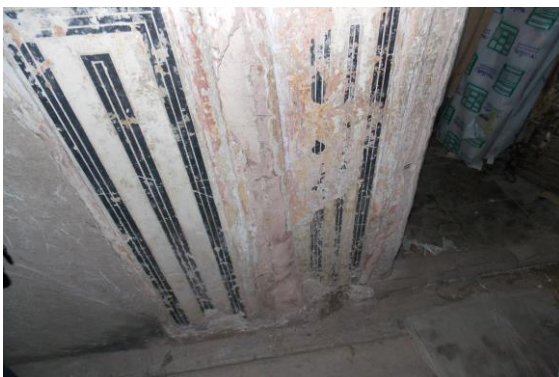
Photo 34

Peeling of Plaster on Frontside wall of Godown No.1 of Ground Floor

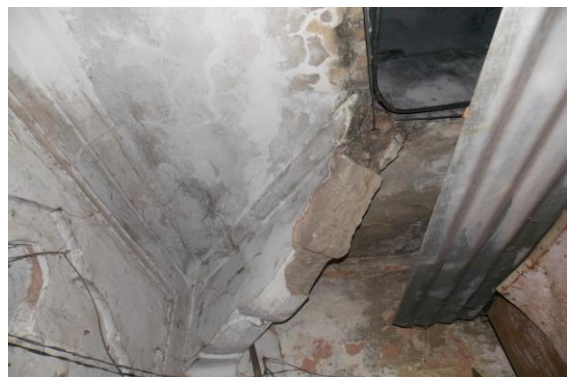
Photo 35

Damaged Portion on Sun shade of Godown No.1 of Ground Floor

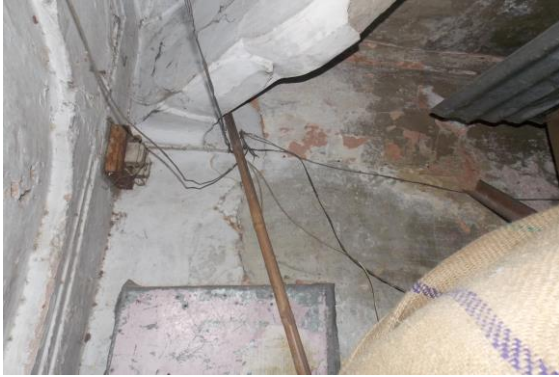
Photo 36

Damaged Portion on Wall No. 3 of Godown No.1 of Ground Floor

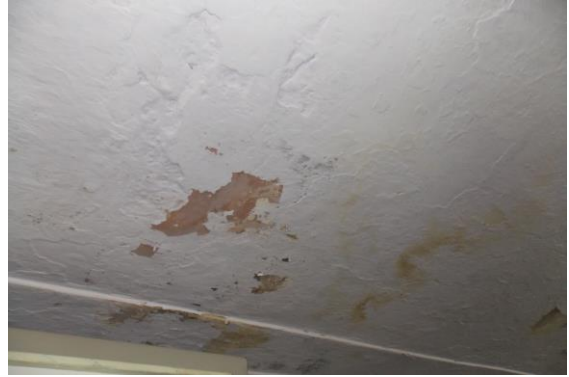
Photo 37

Dampness/Seepage on Roof of Hall No. 1 of Navleshwar Temple, First floor

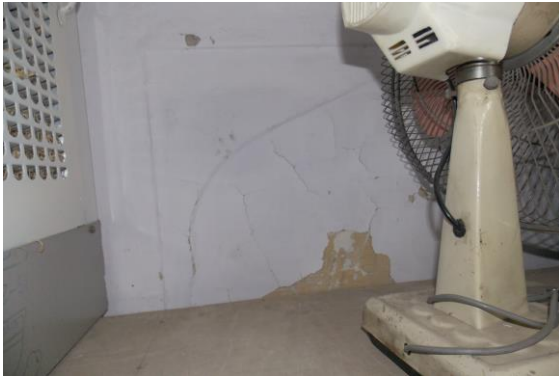
Photo 38

Peeling of Plaster on Wall No. 4 of Navleshwar Temple of First floor

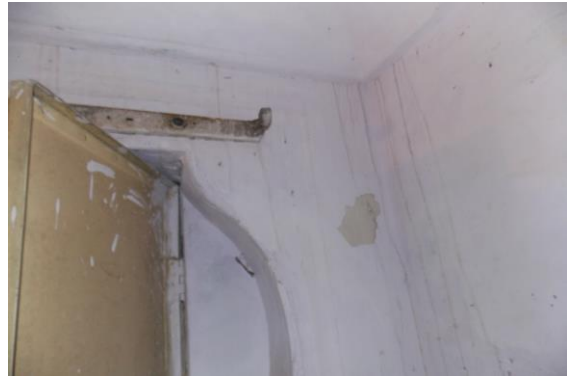
Photo 39

Peeling of Plaster on Wall No. 3 of Navleshwar Temple of First floor

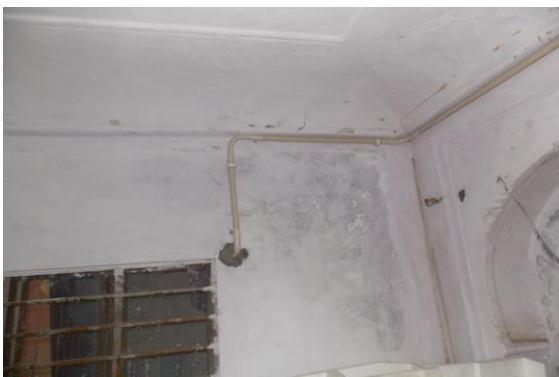
Photo 40

Damaged Portion on Wall No. 2 of Navleshwar Temple of First floor

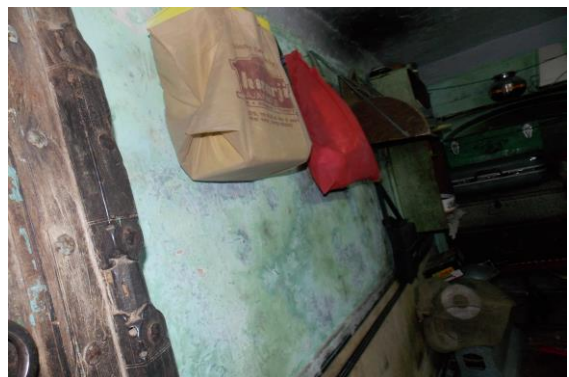
Photo 41

Dampness/Seepage on Wall No. 1 of Store of First floor

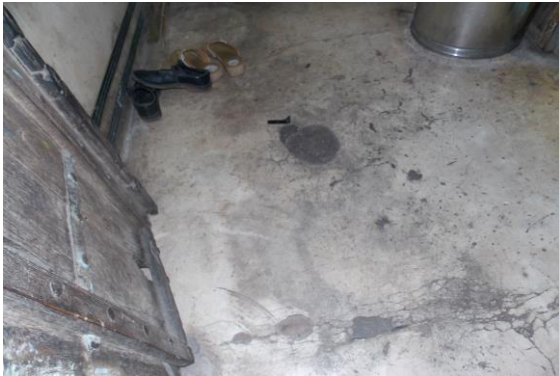
Photo 42
Peeling of Plaster on Floor of Store of First floor

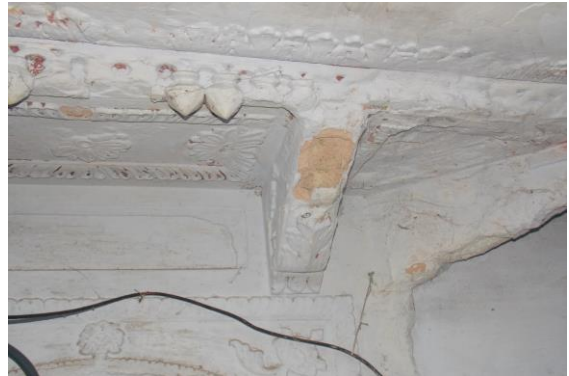
Photo 43
Peeling of Plaster on Roof of Bathroom of Navleshwar Temple, First floor

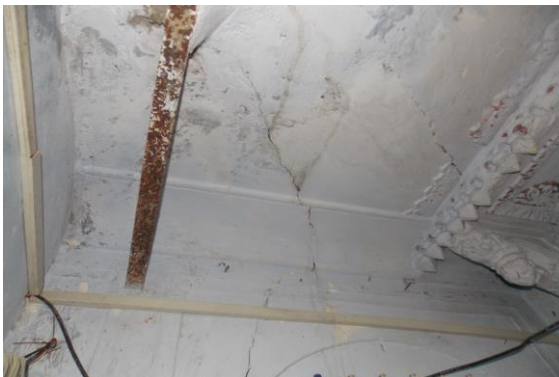
Photo 44
Damaged Portion on Wall No. 1 & Roof of Bathroom No. of Navleshwar Temple, First floor

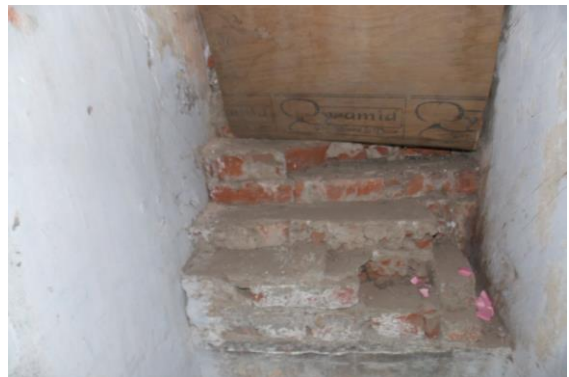
Photo 45
Damaged Portion on Wall No. 3 of Passage of First floor

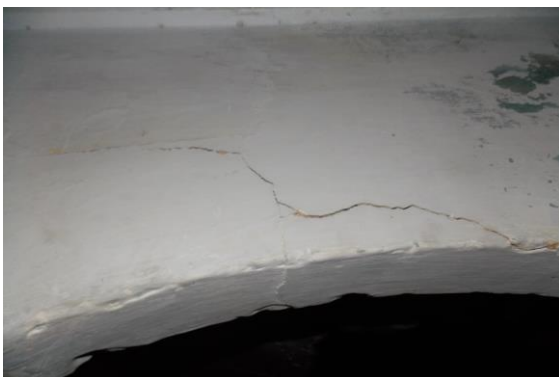
Photo 46
Damaged Portion on Wall No. 1 of Passage of First floor

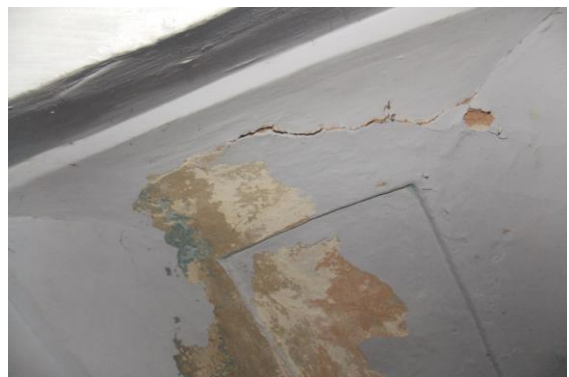
Photo 47
Peeling of Plaster on Roof of Passage of First floor

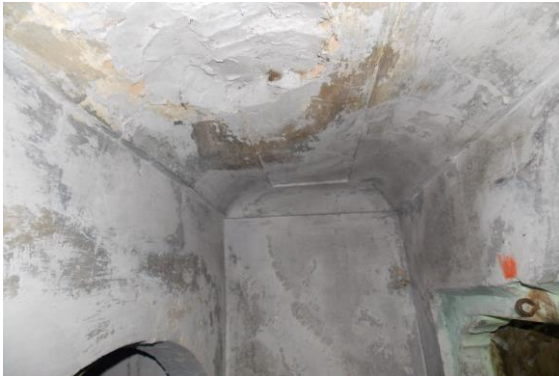
Photo 48

Dampness/Seepage on Wall No. 1, 2, 4 & Roof of Passage of First floor

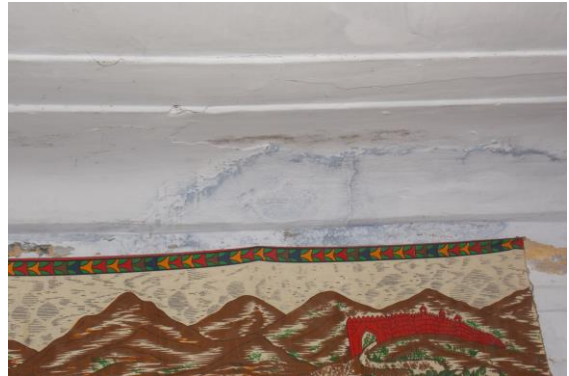
Photo 49

Dampness/Seepage on Wall No. 3 & 1 of Room No. 3 of Navleshwar Temple, First floor

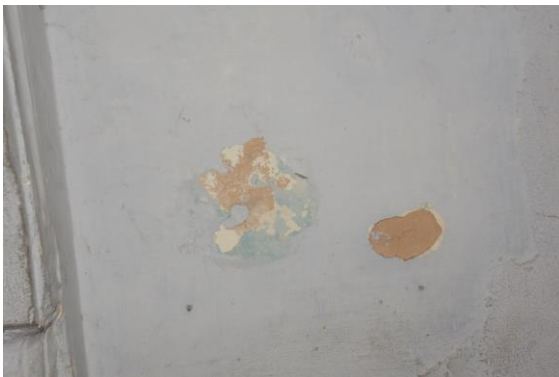
Photo 50

Peeling of Plaster on Wall No. 4 of Room No. 3 of Navleshwar Temple, First floor

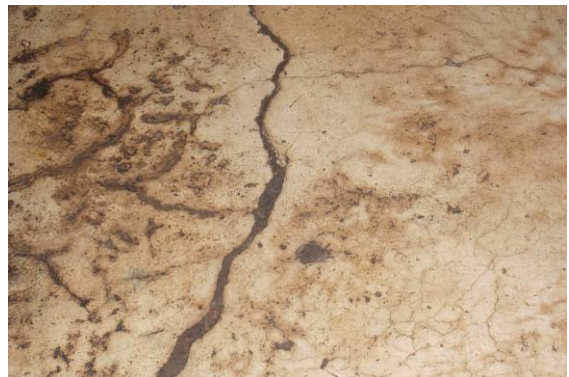
Photo 51

Plaster Crack on Floor of Room No. 3 of Navleshwar Temple, First floor

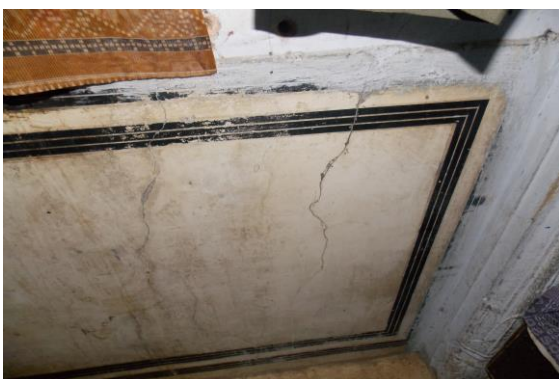
Photo 52

Plaster Crack on Wall No. 4 of Room No. 3 of Navleshwar Temple, First floor

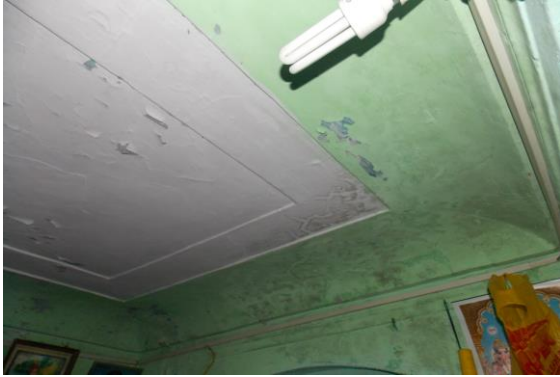
Photo 54

Dampness/Seepage on Roof & Wall No. 3 of Room No. 2 of Navleshwar Temple, First floor

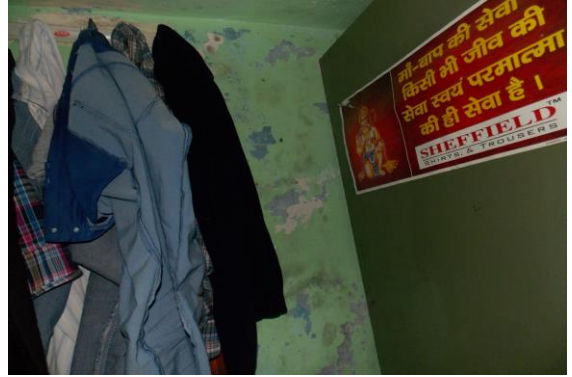
Photo 55

Dampness/Seepage on Wall No. 4 of Room No. 2 of Navleshwar Temple, First floor

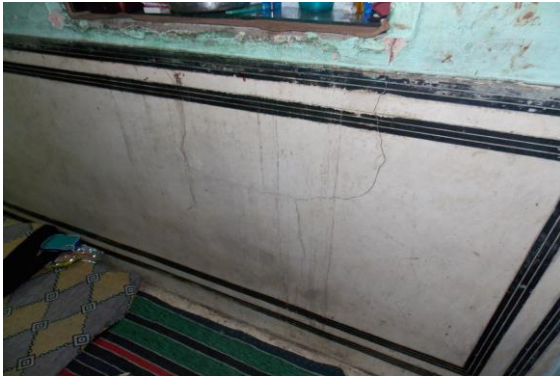
Photo 56

Plaster Crack on Wall No. 4 of Room No. 2 of Navleshwar Temple, First floor

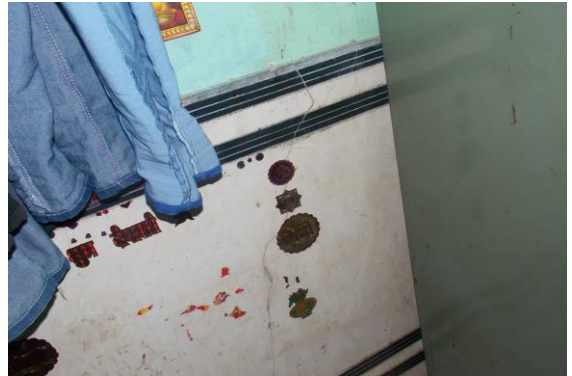
Photo 57

Plaster Crack on Wall No. 4 of Room No. 2 of Navleshwar Temple, First floor

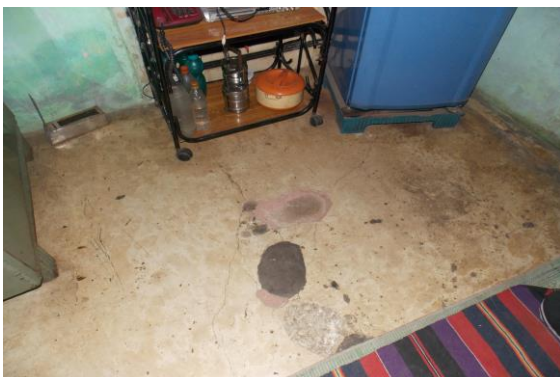
Photo 58

Plaster Crack on Floor of Room No. 2 of Navleshwar Temple, First floor

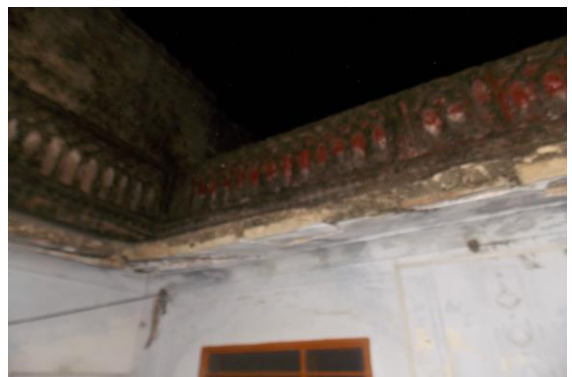
Photo 59

Damaged Portion on Roof & Shade of Open Sky of First floor

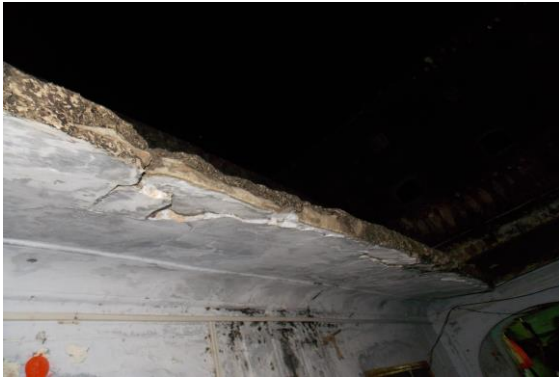
Photo 60
Damaged Portion on Roof & Shade of Open Sky of First floor

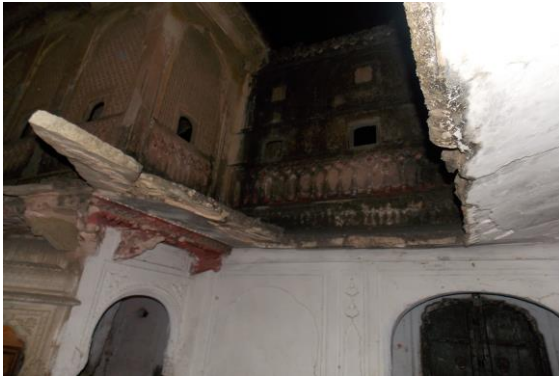
Photo 62
Damaged Portion on Sun Shade of Open Sky of First floor

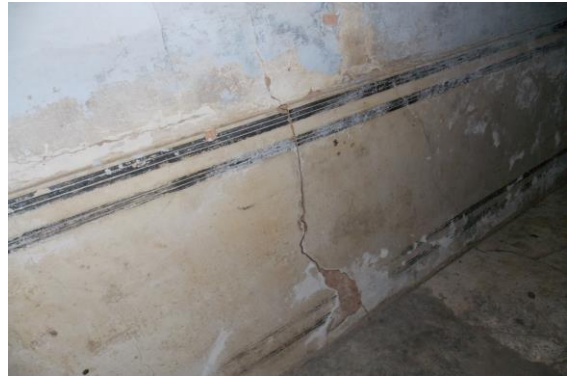
Photo 63
Damaged Portion on Wall No. 4 of Open Sky of First floor

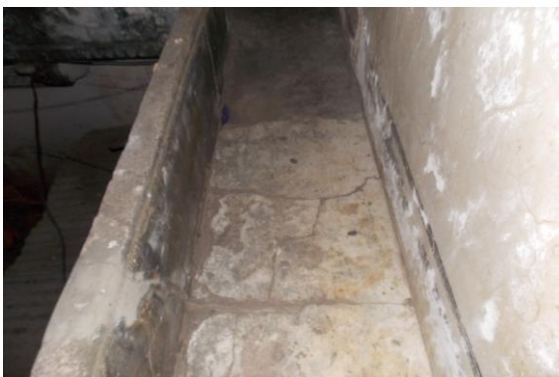
Photo 64
Plaster Crack on Floor of Open Sky of First floor

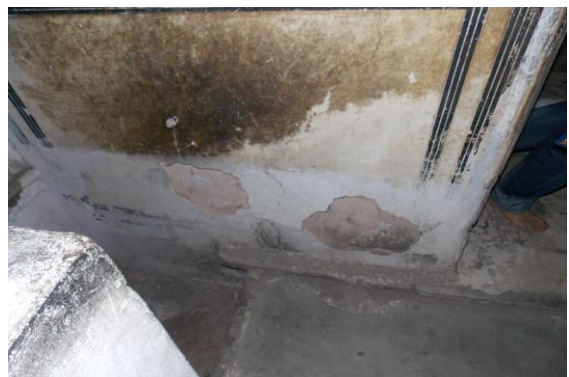
Photo 65
Plaster Crack on Wall No. 3 of Staircase Ground Floor to First Floor

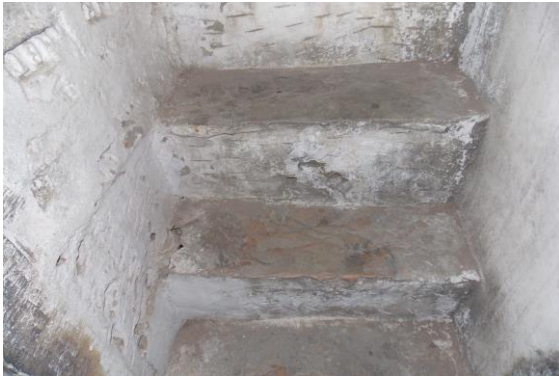
Photo 66
Damaged Portion on of Staircase Ground Floor to First Floor

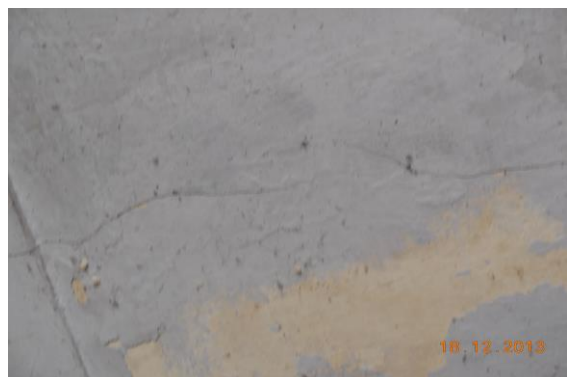
Photo 6
Inclined Crack on Roof of Main Gate, Neel mani Ji Ka Temple, Ground Floor, Approx. Width = 0.5mm, Approx. Length = 2m. Distance from Wall No.1 = 0m, Height from Floor = 3m.

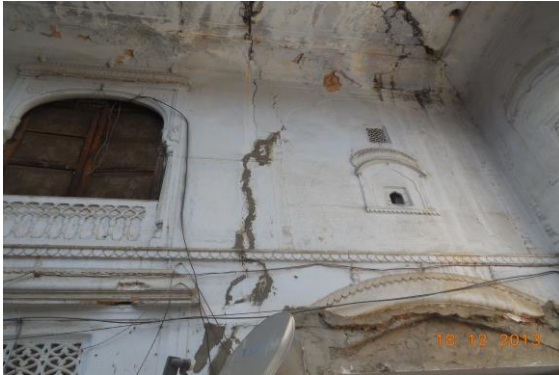
Photo 7

Inclined Crack on Wall No. 1 & Roof Shade of Open Sky, Neel mani Ji Ka Temple, G. Floor, Approx. Width = 10mm, Approx. Length = 5m. Distance from Wall No.4 = 2.5m, Height from Floor = 0m.

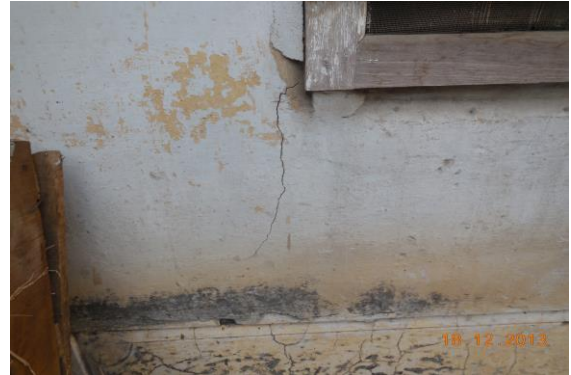
Photo 8

Inclined Crack on Wall No. 1 of Open Sky, Neel mani Ji Ka Temple, Ground Floor, Approx. Width = 1mm, Approx. Length = 0.8m. Distance from Wall No.3 = 3m, Height from Floor = 0.6m.

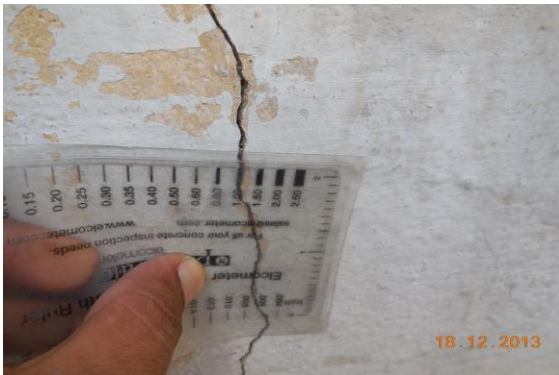
Photo 8A

Inclined Crack on Wall No. 1 of Open Sky, Neel mani Ji Ka Temple, Ground Floor, Approx. Width = 1mm, Approx. Length = 0.8m. Distance from Wall No.3 = 3m, Height from Floor = 0.6m.

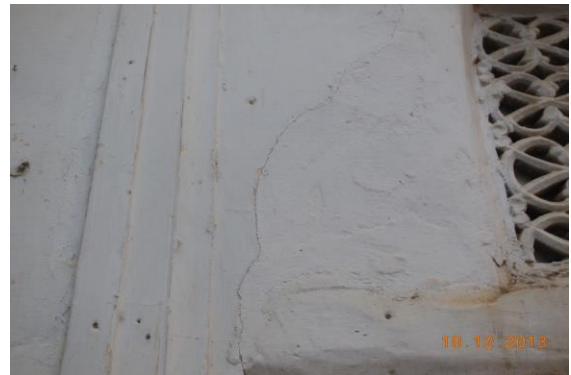
Photo 9

Inclined Crack on Wall No. 1 of Open Sky, Neel mani Ji Ka Temple, Ground Floor, Approx. Width = 0.15mm, Approx. Length = 3m. Distance from Wall No.3 = 2.8m, Height from Floor = 0m.

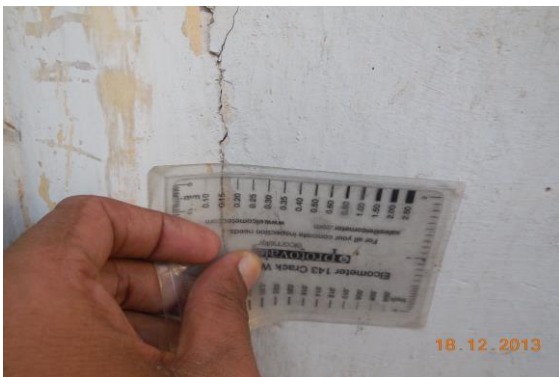
Photo 9A

Inclined Crack on Wall No. 1 of Open Sky, Neel mani Ji Ka Temple, Ground Floor, Approx. Width = 0.15mm, Approx. Length = 3m. Distance from Wall No.3 = 2.8m, Height from Floor = 0m.

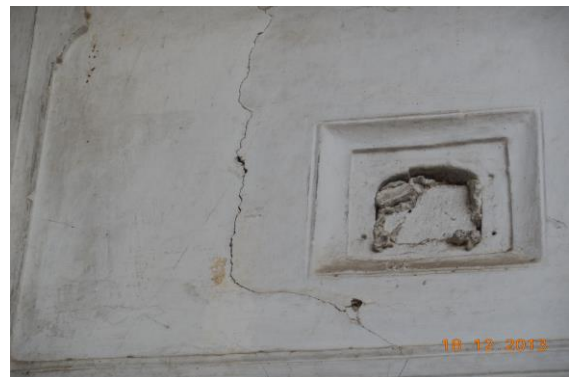
Photo 10

Inclined Crack on Wall No. 3 of Open Sky, Neel mani Ji Ka Temple, First Floor, Approx. Width = 0.8mm, Approx. Length = 2.5m. Distance from Wall No.2 = 1m, Height from Floor = 3m.

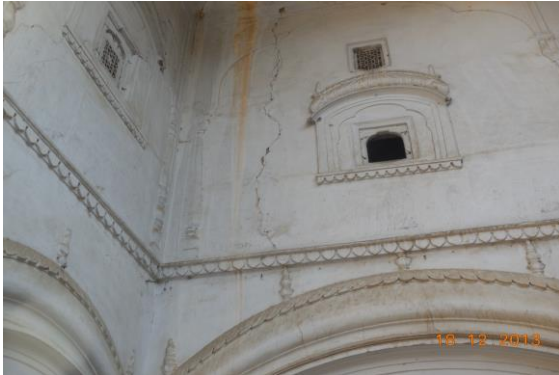
Photo 11

Inclined Crack on Wall No. 2 of Open Sky, Neel mani Ji Ka Temple, First Floor, Approx. Width = 1mm, Approx. Length = 3m. Distance from Wall No.4 = 0.6m, Height from Floor = 3.2m.

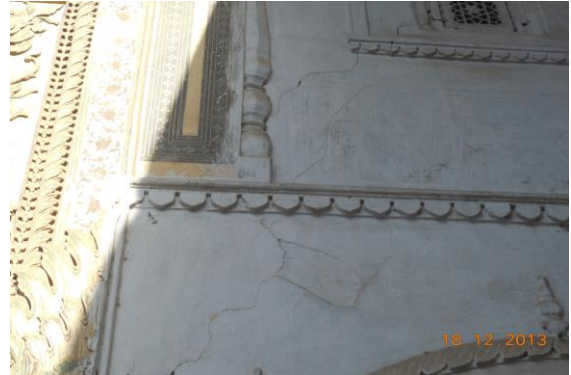
Photo 12

Inclined Crack on Wall No. 4 of Open Sky, Neel mani Ji Ka Temple, First Floor, Approx. Width = 1.5mm, Approx. Length = 5.5m. Distance from Wall No.2 = 1.8m, Height from Floor = 2.6m.
