Pre Building Condition Survey Report

Name and Address of Structure :	Choti Chopar to Badi Chopar (UP Line)
---------------------------------	---------------------------------------

Name of the Project	Contract JMRC-UG1B “Design and Construction of Tunnel between Chandpole and Badi Chouper and reverse line by Shield TBM, Underground Metro Stations at Choti Chouper and Badi Chouper by Cut and Cover Methods on East West Corridor of Jaipur Metro Rail Corporation Limited .”	
Owner :

Shoping Complex - Shop No. 169-188
Tripolia Bazar
Jaipur
Unique ID: CC BC UP 0001

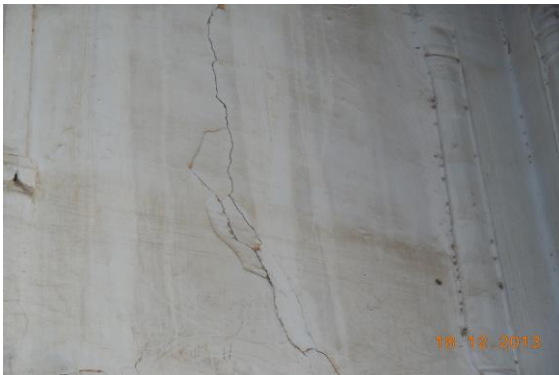
Photo 13

Inclined Crack on Wall No. 1 of Open Sky, Neel mani Ji Ka Temple, First Floor, Approx. Width = 0.8mm, Approx. Length = 2.5m. Distance from Wall No.4 = 0.3m, Height from Floor = 3m.

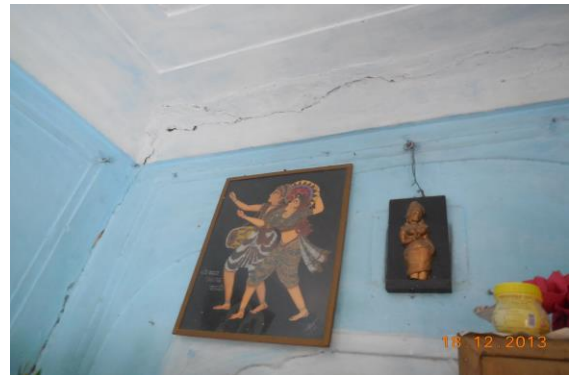
Photo 14

Inclined Crack on Wall No. 2 & 4 of Room No. 1, Neel Mani Ji Ka Temple Ground Floor, Approx. Width = 1mm, Approx. Length = 3m. Height from Floor = 1m.

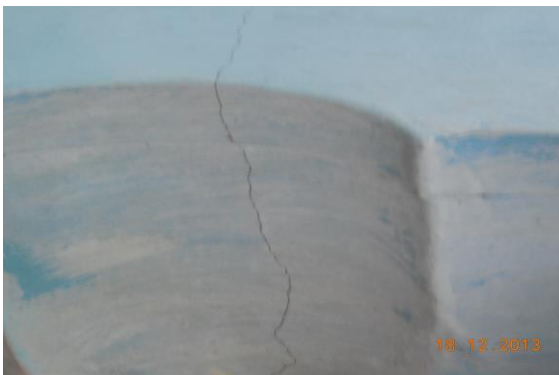
Photo 15

Inclined Crack on Wall No. 3 of Room No. 1, Neel Mani Ji Ka Temple Ground Floor, Approx. Width = 0.6mm, Approx. Length = 0.7m. Distance from Wall No.2 = 1.2m, Height from Floor = 2.5m.

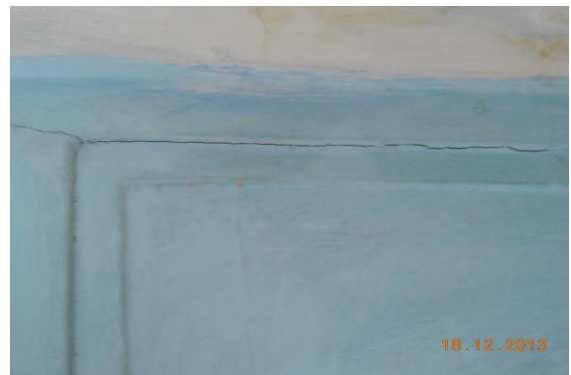
Photo 16

Horizontal Crack on Wall No. 3 of Room No. 1, Neel Mani Ji Ka Temple Ground Floor, Approx. Width = 1mm, Approx. Length = 1.25m. Distance from Wall No.4 = 1m, Height from Floor = 2.8m.

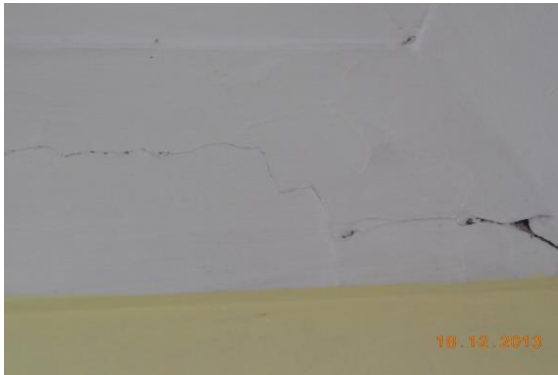
Photo 17

Inclined Crack on Roof of Kitchen, Neel mani Ji Ka Temple, Ground Floor, Approx. Width = 2.5mm, Approx. Length = 2m. Distance from Wall No.4 = 0m, Height from Floor = 2.8m.

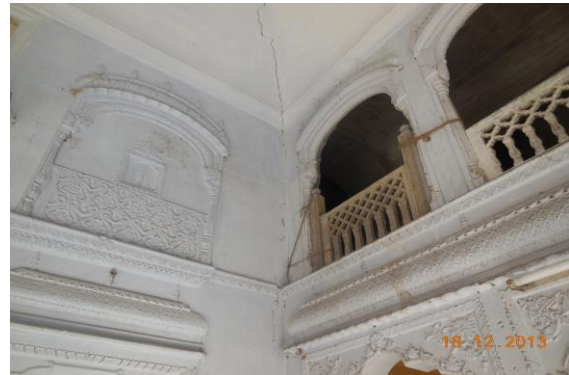
Photo 18

Inclined Crack on Wall No. 4 & Roof of Varanda No.3, Neel mani Ji Ka Temple, Ground Floor, Approx. Width = 2.5mm, Approx. Length = 9.5m. Distance from Wall No.4 & 2 = 0m, Height Floor = 2.8m.

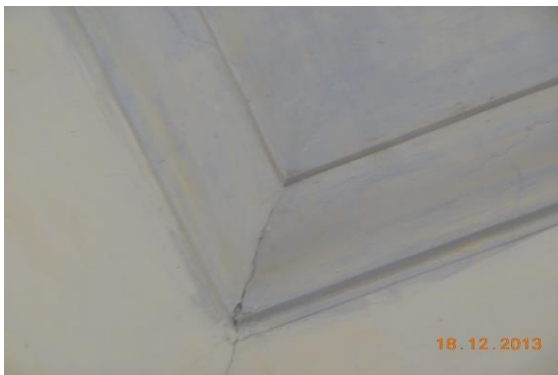
Photo 19

Inclined Crack on Wall No. 4 & Roof of Varanda No.3, Neel mani Ji Ka Temple, Ground Floor, Approx. Width = 2.5mm, Approx. Length = 9.5m. Distance from Wall No.4 & 2 = 0m, Height Floor = 2.8m.

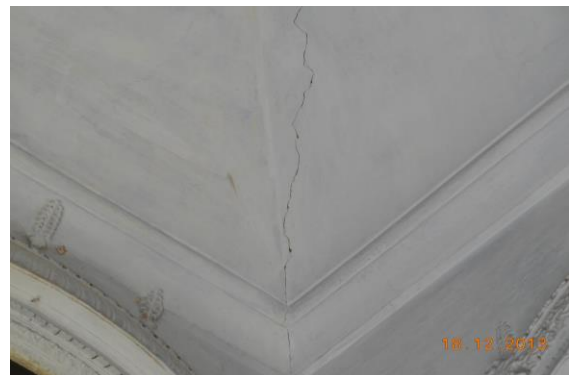
Photo 20

Inclined Crack on Wall No. 1 & 4 of Varanda No.3, Neel mani Ji Ka Temple, Ground Floor, Approx. Width = 1mm, Approx. Length = 8.5m. Distance from Wall No.1 & 4 = 0m, Height from Floor = 5m.

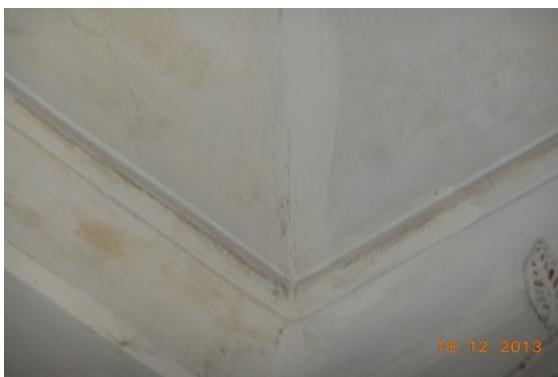
Photo 20A

Inclined Crack on Wall No. 1 & 4 of Varanda No.3, Neel mani Ji Ka Temple, Ground Floor, Approx. Width = 1mm, Approx. Length = 8.5m. Distance from Wall No.1 & 4 = 0m, Height from Floor = 5m.

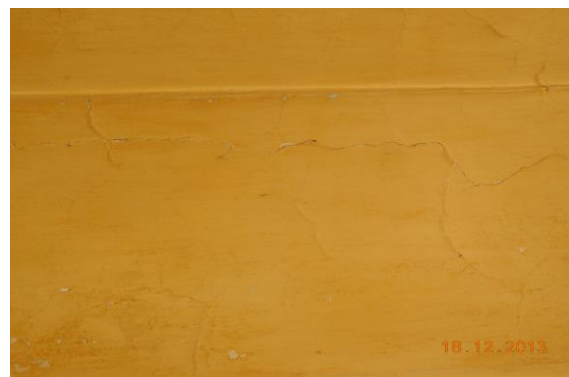
Photo 21

Inclined Crack on Roof of Passage No.1, Neel mani Ji Ka Temple, Ground Floor, Approx. Width = 0.35mm, Approx. Length = 2m. Distance from Wall No.1 = 0m, Height from Floor = 2.9m.

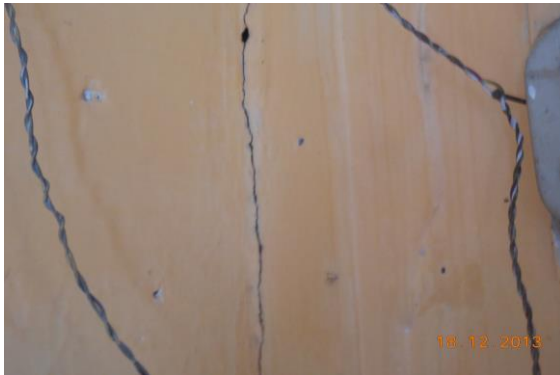
Photo 22

Vertical Crack on Wall No. 1, 4 & Corner of Staircase Ground Floor To F F, Neel mani Ji Ka Temple, G Floor, Approx. Width = 2mm, Approx. Length = 2m.

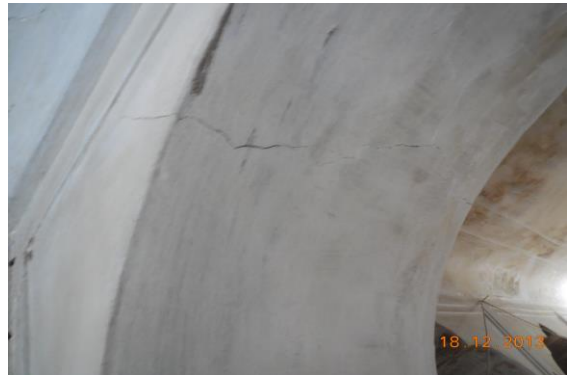
Photo 23

Inclined Crack on Gate Roof of Gallery No.4, Neel mani Ji Ka Temple, First Floor, Approx. Width = 1mm, Approx. Length = 1.5m. Distance from Wall No.3 = 1.3m, Height from Floor = 2.1m.

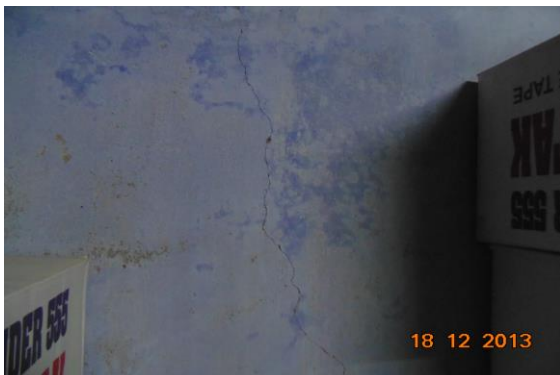
Photo 24

Inclined Crack on Wall No. 4 of Varanda No.2, Neel mani Ji Ka Temple, Lower Ground Floor, Approx. Width = 0.4mm, Approx. Length = 1.2m. Distance from = 1m, Height from Floor = 1m.

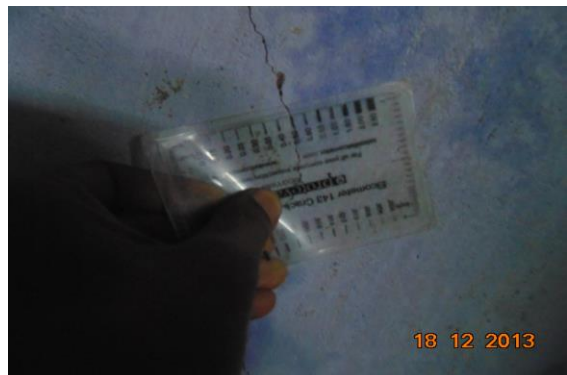
Photo 24A

Inclined Crack on Wall No. 4 of Varanda No.2, Neel mani Ji Ka Temple, Lower Ground Floor, Approx. Width = 0.4mm, Approx. Length = 1.2m. Distance from = 1m, Height from Floor = 1m.

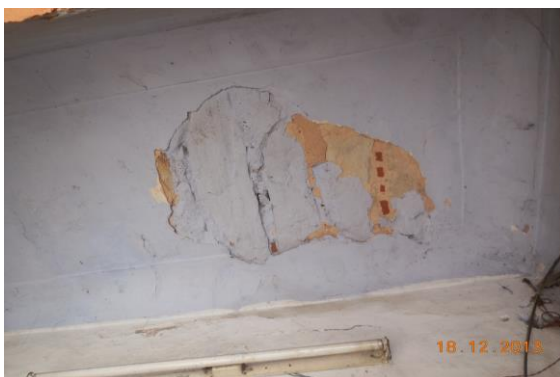
Photo 25

Damaged Portion on Roof of Main Gate of Neel mani Ji Ka Temple, Ground Floor

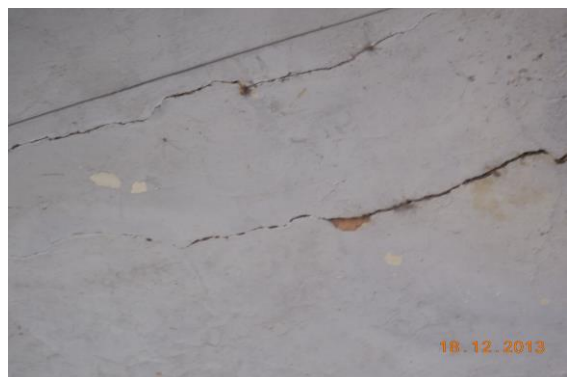
Photo 26

Plaster Crack on Roof of Main Gate of Neel mani Ji Ka Temple, Ground Floor

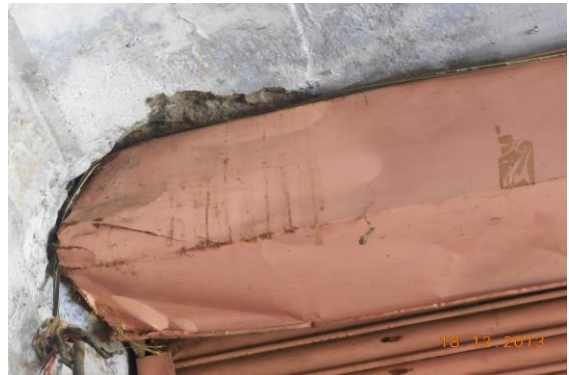
Photo 28

Damaged Portion on Roof of Main Gate of Neel mani Ji Ka Temple, Ground Floor

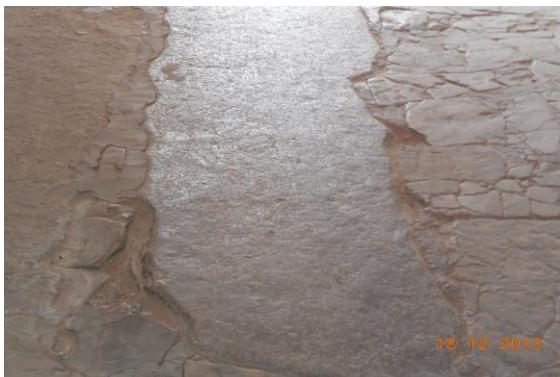
Photo 29

Damaged Portion on Floor of Main Gate of Neel mani Ji Ka Temple, Ground Floor

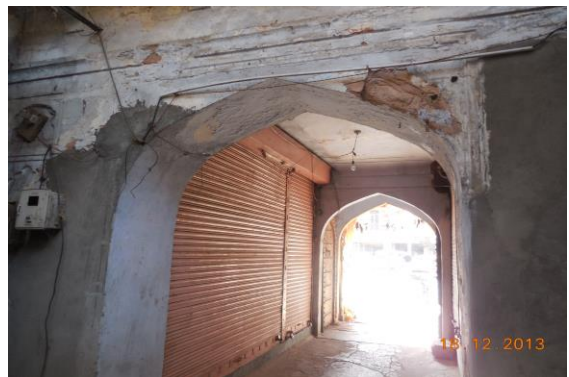
Photo 30

Damaged Portion on Wall No. 3 of Main Gate of Neel mani Ji Ka Temple, Ground Floor

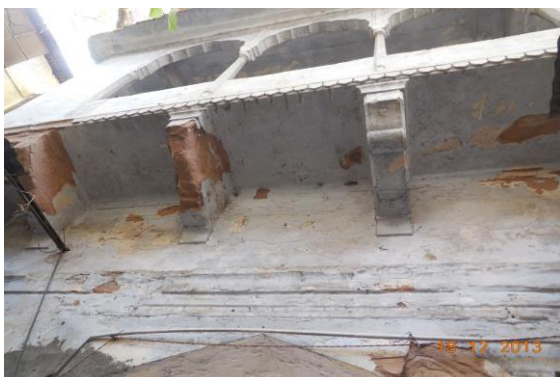
Photo 31

Peeling of Plaster on Wall No. 3 & Roof Shade of Open Sky of Neel mani Ji Ka Temple, Ground Floor

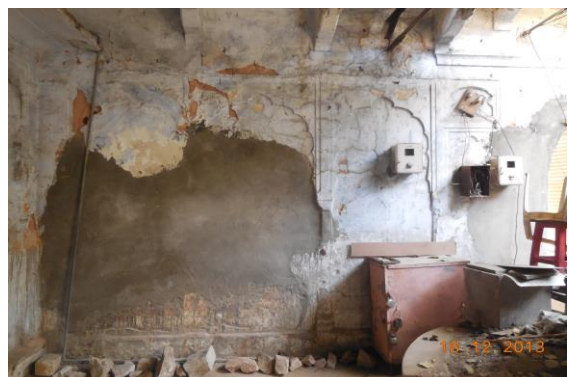
Photo 32

Peeling of Plaster on Wall No. 2 of Varanda no.2 of Neel mani Ji Ka Temple, Ground Floor

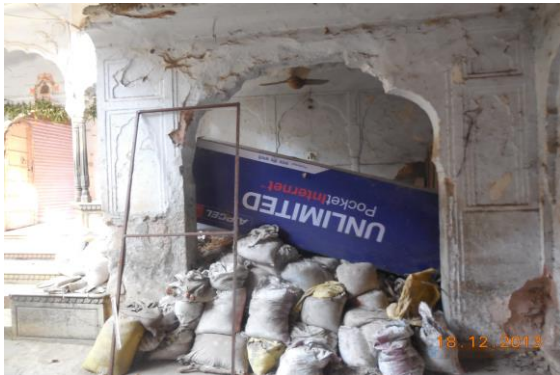
Photo 33

Damaged Portion on Wall No. 1 of Varanda no.2 of Neel mani Ji Ka Temple, Ground Floor

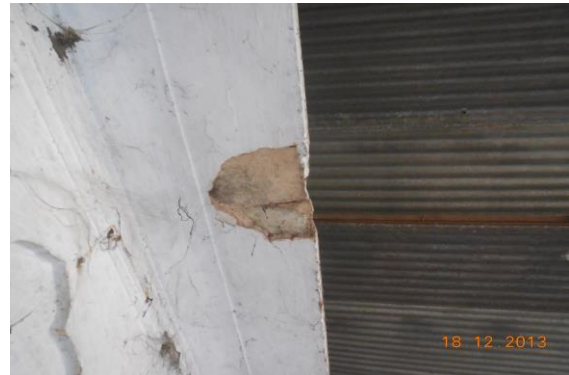
Photo 34

Damaged Portion on Wall No. 4 & Shade of Varanda no.2 of Neel mani Ji Ka Temple, Ground Floor

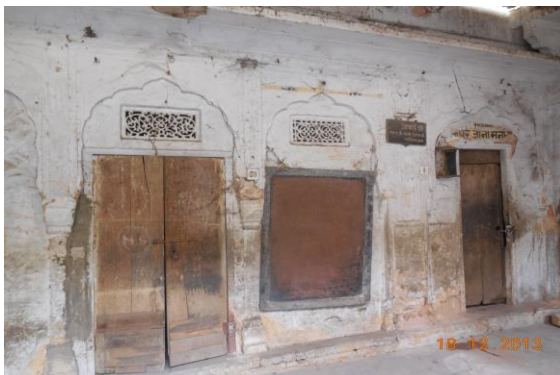
Photo 35

Peeling of Plaster on Wall No. 4 of Varanda no.2 of Neel mani Ji Ka Temple, Ground Floor

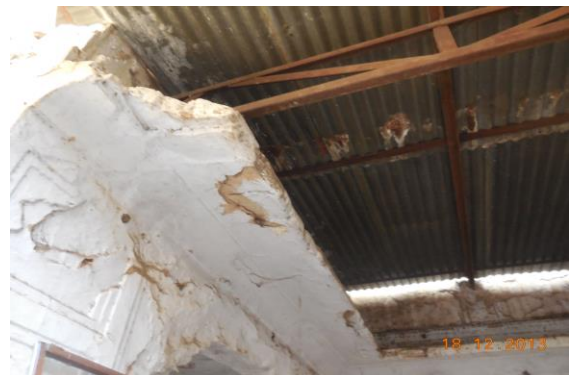
Photo 36

Damaged Portion on Wall No. 1 & Shade of Varanda No.2 of Neel mani Ji Ka Temple, Ground Floor

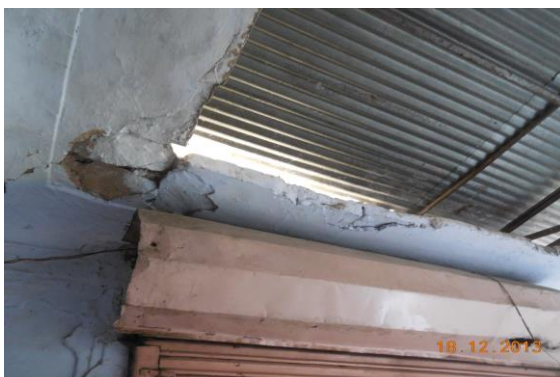
Photo 37

Damaged Portion on Wall No. 2 & Shade of Varanda no.1 of Neel mani Ji Ka Temple, Ground Floor

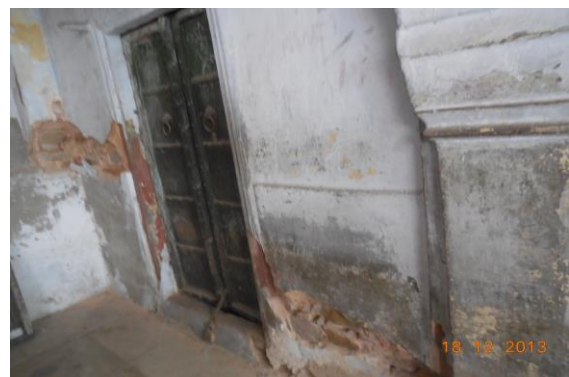
Photo 38

Damaged Portion on Wall No. 2 & 4 of Varanda no.1 of Neel mani Ji Ka Temple, Ground Floor

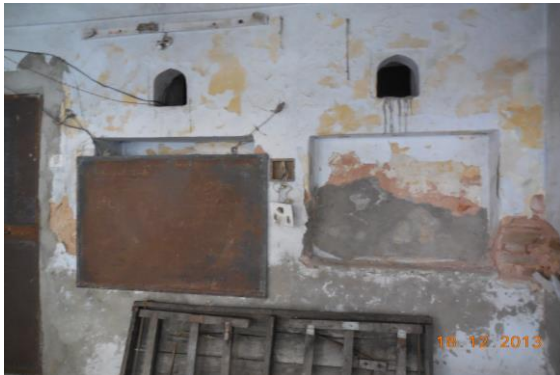
Photo 39

Peeling of Plaster of Varanda no.1 of Neel mani Ji Ka Temple, Ground Floor

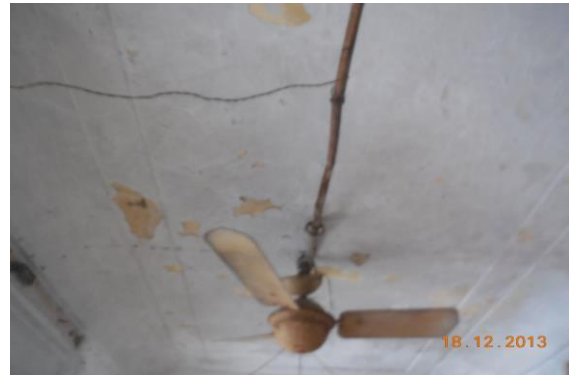
Photo 40

Dampness/Seepage on Roof of Varanda no.1 of Neel mani Ji Ka Temple, Ground Floor

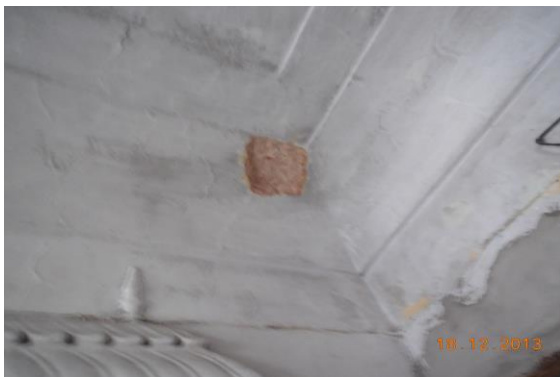
Photo 41

Peeling of Plaster on Roof of Varanda no.1 of Neel mani Ji Ka Temple, Ground Floor

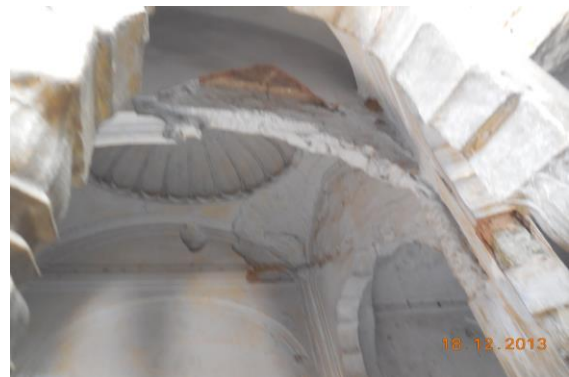
Photo 42

Peeling of Plaster on Roof of Tomb No.2 of Varanda No.2 of Neel mani Ji Ka Temple, Ground Floor

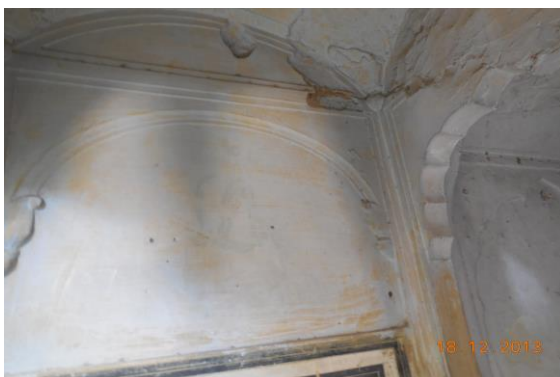
Photo 43

Peeling of Plaster on Wall No. 4 of Tomb No.2 of Varanda No.2 of Neel mani Ji Ka Temple, Ground Floor

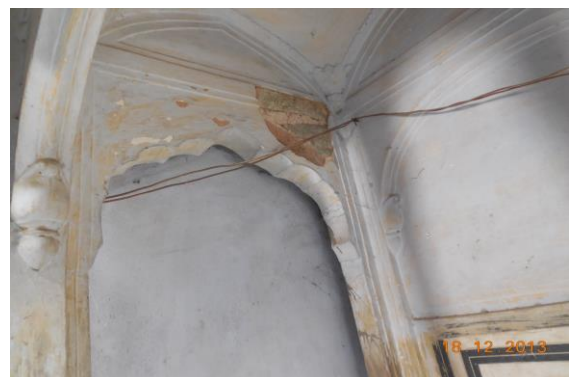
Photo 44

Peeling of Plaster on Wall No. 1 of Tomb No.1 of Varanda No.2 of Neel mani Ji Ka Temple, Ground Floor

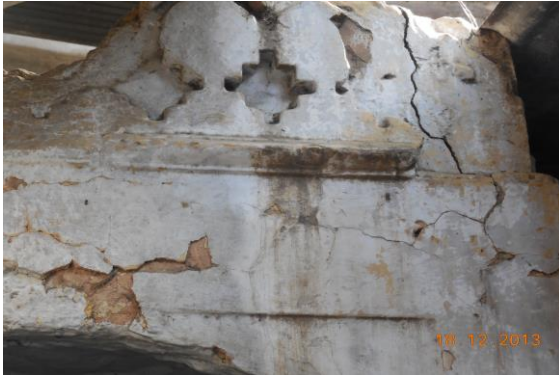
Photo 45

Damaged Portion on Outer Wall of Varanda No.2 of Neel mani Ji Ka Temple, Ground Floor

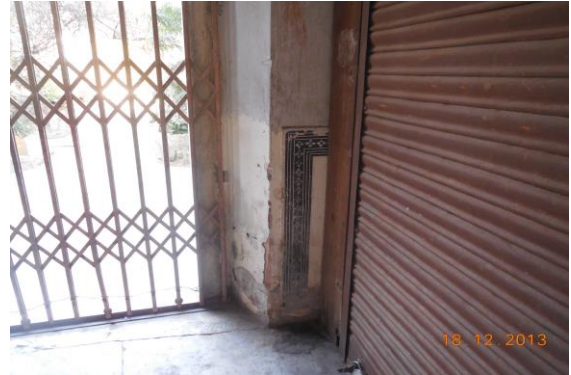
Photo 46

Peeling of Plaster on Wall No. 4 of Gate of Neel mani Ji Ka Temple, Ground Floor

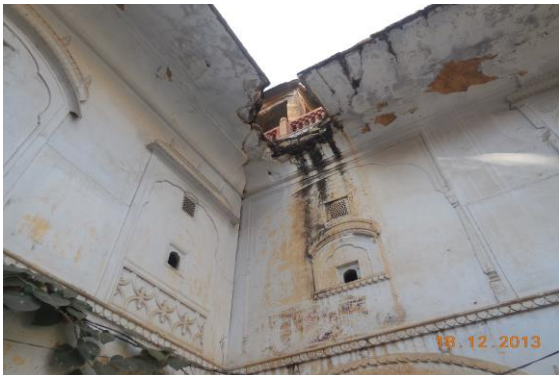
Photo 47

Damaged Portion on Wall No. 1, 3 & Roof Shade of Open Sky of Neel mani Ji Ka Temple, First Floor

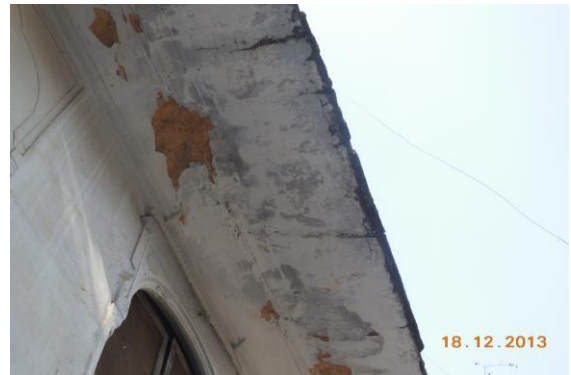
Photo 48

Peeling of Plaster on Wall No. 1 & Roof Shade of Open Sky of Neel mani Ji Ka Temple, First Floor

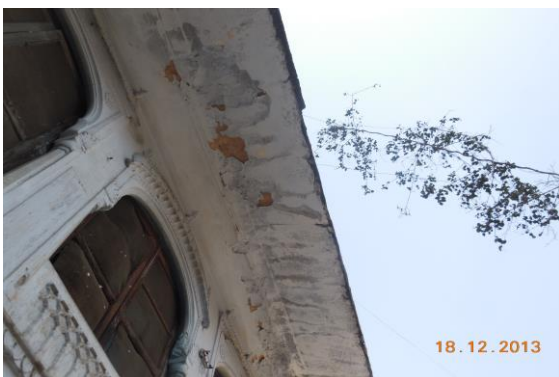
Photo 49

Peeling of Plaster on Wall No. 1 & Roof Shade of Open Sky of Neel mani Ji Ka Temple, First Floor

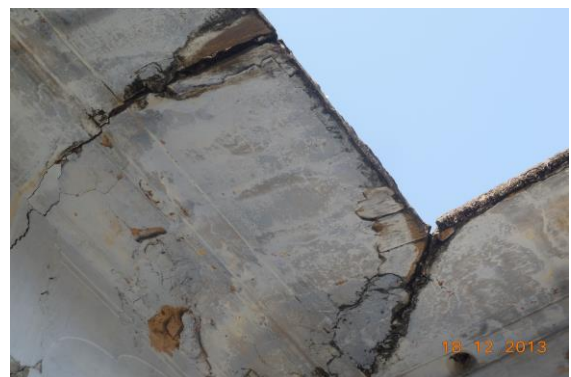
Photo 50

Damaged Portion on Wall No. 1 & 4 of Open Sky of Neel mani Ji Ka Temple, First Floor

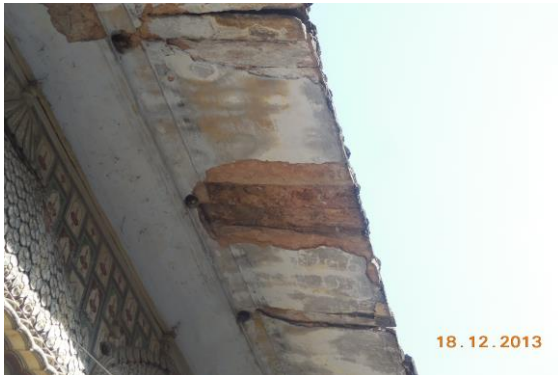
Photo 51

Damaged Portion on Shade of Open Sky of Neel mani Ji Ka Temple, First Floor

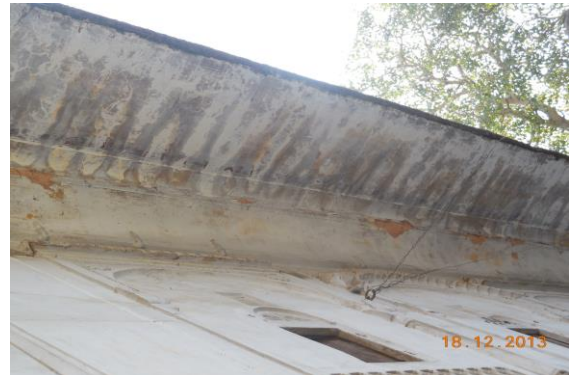
Photo 52

Dampness/Seepage on Wall No. 2 & Roof Shade of Open Sky of Neel mani Ji Ka Temple, First Floor

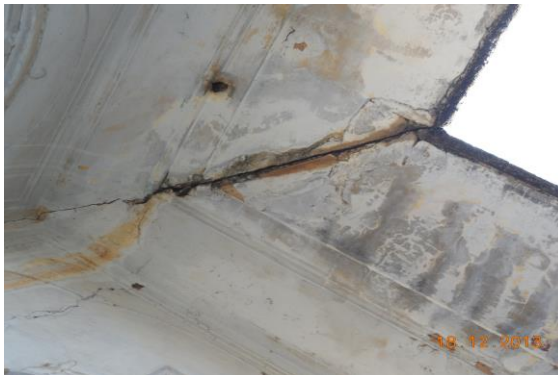
Photo 53

Dampness/Seepage on Wall No. 1, 4 & Corner shade of Open Sky of Neel mani Ji Ka Temple, First Floor

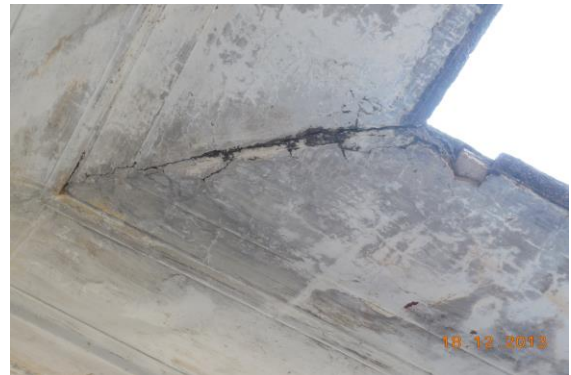
Photo 54

Damaged Portion on Wall No. 2, 3 & Corner shade of Open Sky of Neel mani Ji Ka Temple, First Floor

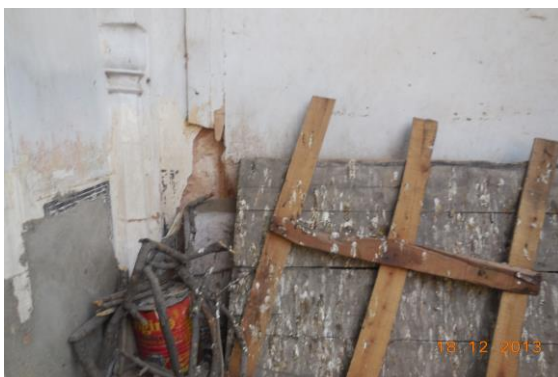
Photo 55

Peeling of Plaster on Wall No. 3 of Open Sky of Neel mani Ji Ka Temple, Ground Floor

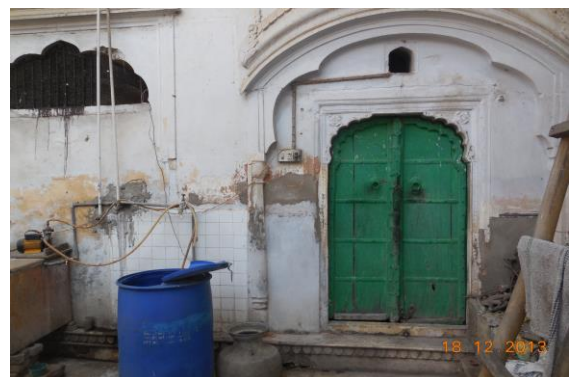
Photo 56

Peeling of Plaster on Wall No. 2 of Open Sky of Neel mani Ji Ka Temple, Ground Floor

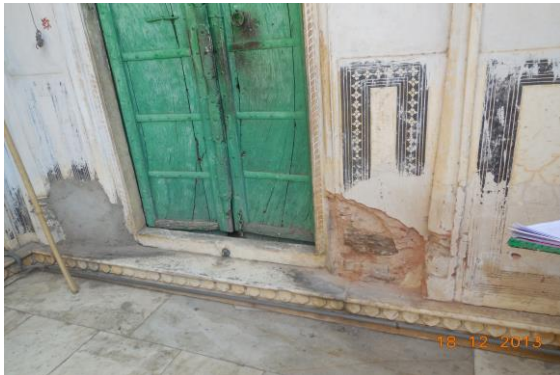
Photo 57

Peeling of Plaster on Wall No. 2 of Open Sky of Neel mani Ji Ka Temple, Ground Floor

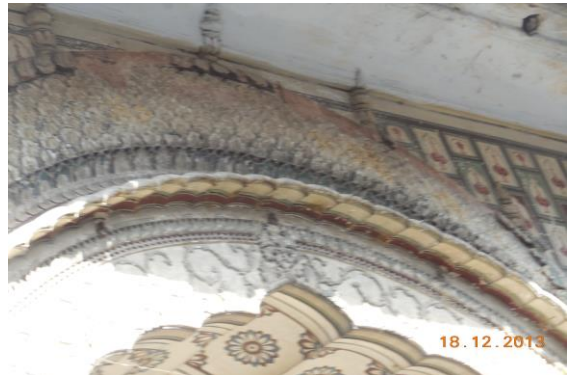
Photo 58

Peeling of Plaster on Wall No. 4 of Open Sky of Neel mani Ji Ka Temple, Ground Floor

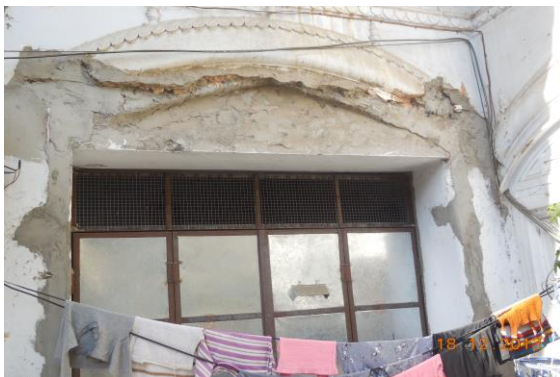
Photo 59

Peeling of Plaster on Wall No. 1 of Open Sky of Neel mani Ji Ka Temple, Ground Floor

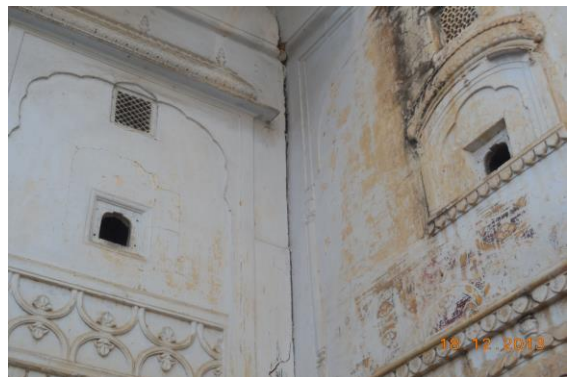
Photo 60

Damaged Portion on Wall No. 1 & 3 of Open Sky of Neel mani Ji Ka Temple, Ground Floor

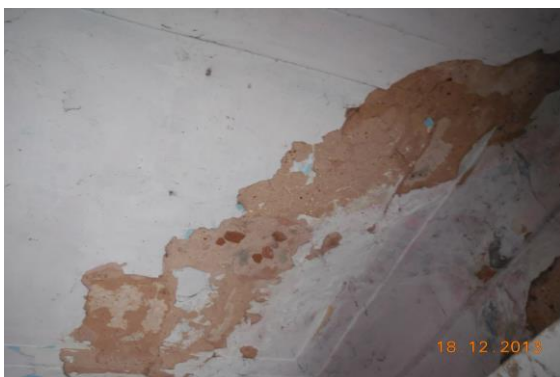
Photo 61

Peeling of Plaster on Roof of Toilet No. 1 of Neel Mani Ji Ka Temple Ground Floor

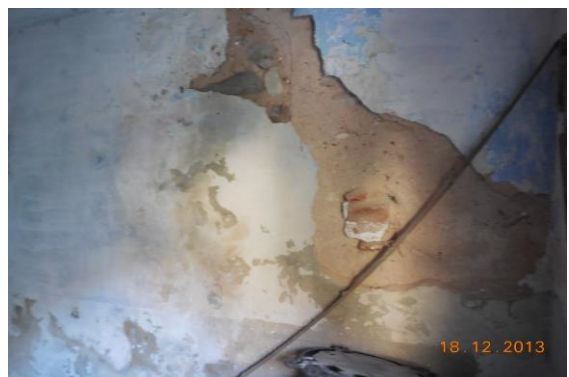
Photo 62

Peeling of Plaster on Wall No. 2 of Toilet No. 1 of Neel Mani Ji Ka Temple Ground Floor

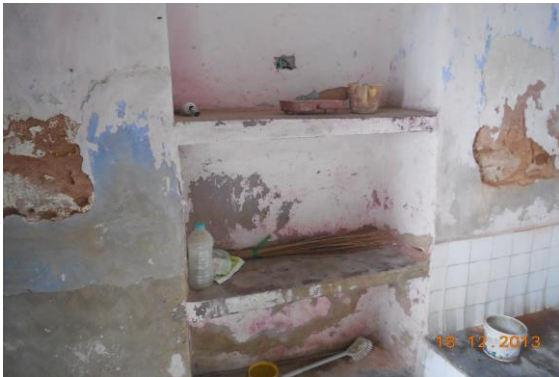
Photo 63

Peeling of Plaster on Wall No. 1 of Toilet No. 1 of Neel Mani Ji Ka Temple Ground Floor

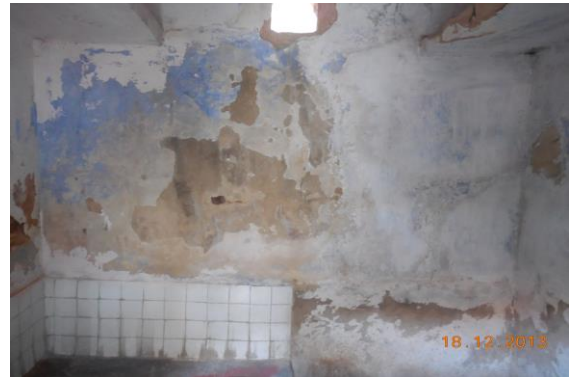
Photo 64

Peeling of Plaster on Wall No. 4 of Toilet No. 1 of Neel Mani Ji Ka Temple Ground Floor

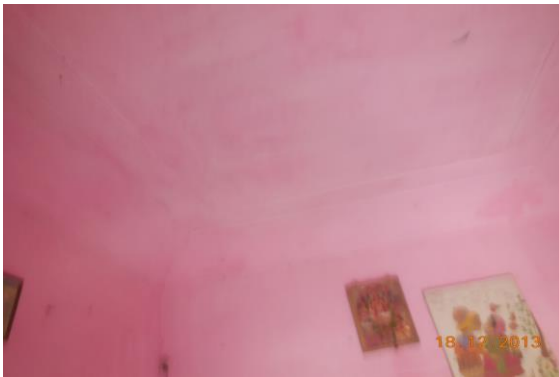
Photo 65

Dampness/Seepage on Roof of Store of Neel man Ji Ka Temple, Ground Floor

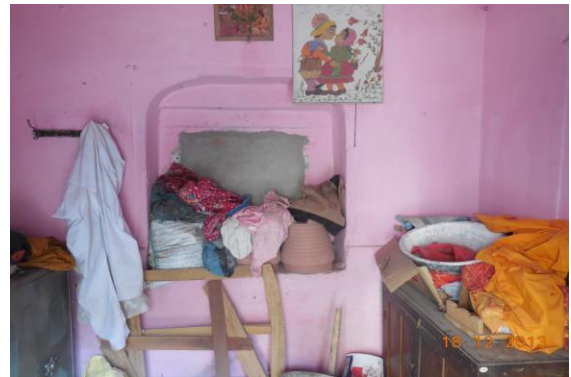
Photo 66

Peeling of Plaster on Wall No. 4 of Store of Neel man Ji Ka Temple, Ground Floor

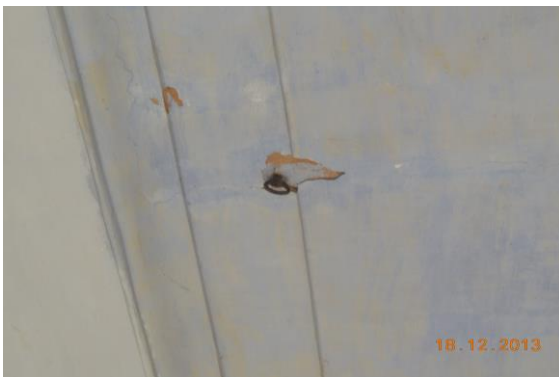
Photo 67

Peeling of Plaster on Wall No. 3 & Roof of Varanda No.3 of Neel man Ji Ka Temple, Ground Floor

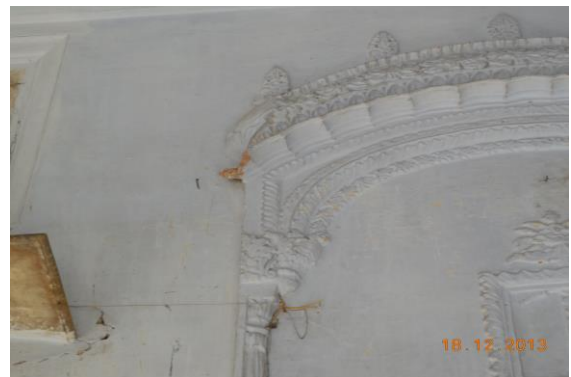
Photo 68

Damaged Portion on Wall No. 3 & Outer Wall of Main Temple of Neel man Ji Ka Temple, Ground Floor

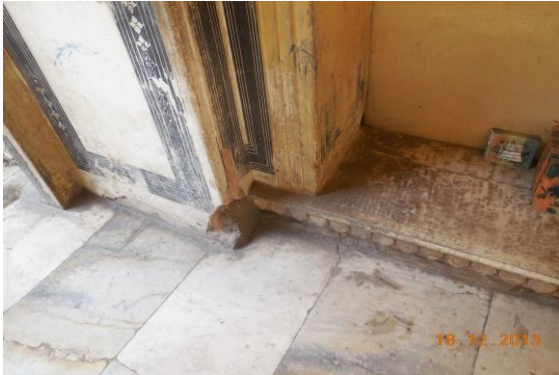
Photo 69

Damaged Portion on Wall No. 1 of Passage No.1 of Neel mani Ji Ka Temple, Ground Floor

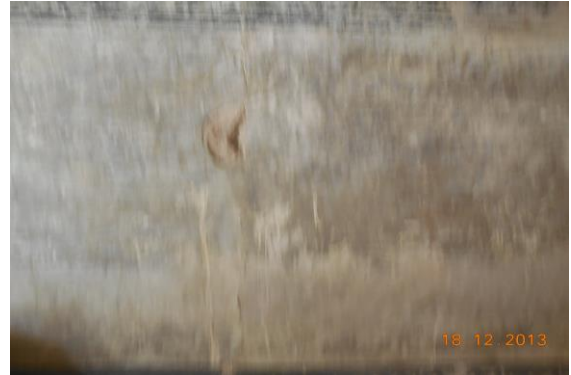
Photo 70

Plaster Crack on Wall No. 1 of Passage No.1 of Neel mani Ji Ka Temple, Ground Floor

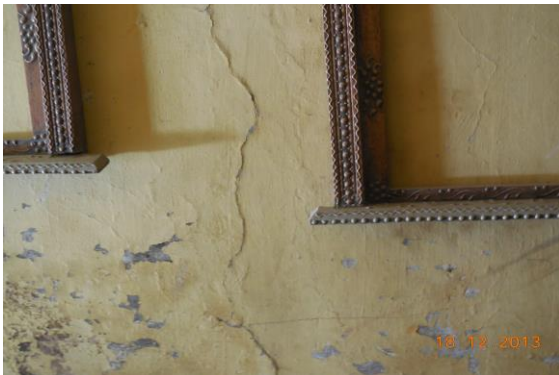
Photo 71

Plaster Crack on Wall No. 1 of Passage No.1 of Neel mani Ji Ka Temple, Ground Floor

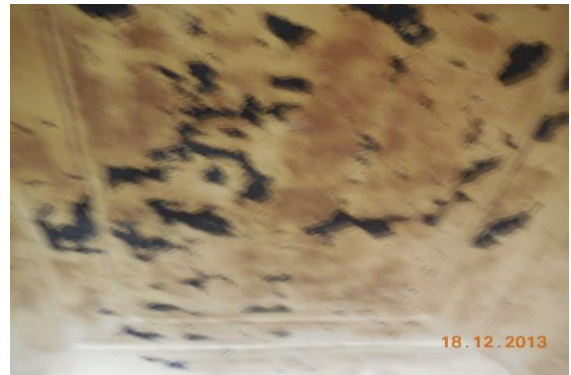
Photo 72

Dampness/Seepage on Roof of Passage No.2 of Neel mani Ji Ka Temple, Ground Floor

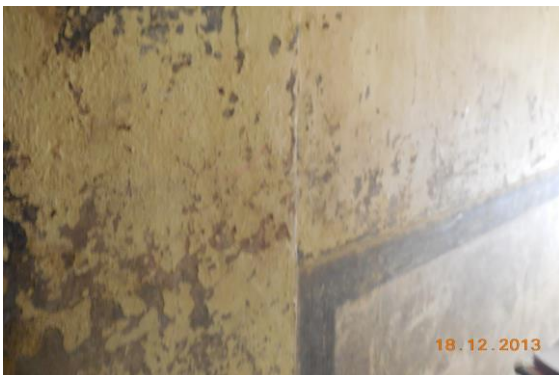
Photo 73

Peeling of Plaster on Wall No. 2 of Passage No.1 of Neel mani Ji Ka Temple, Ground Floor

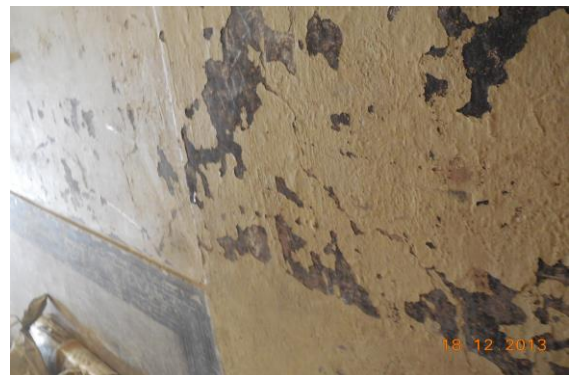
Photo 74

Peeling of Plaster on Wall No. 1 of Passage No.1 of Neel mani Ji Ka Temple, Ground Floor

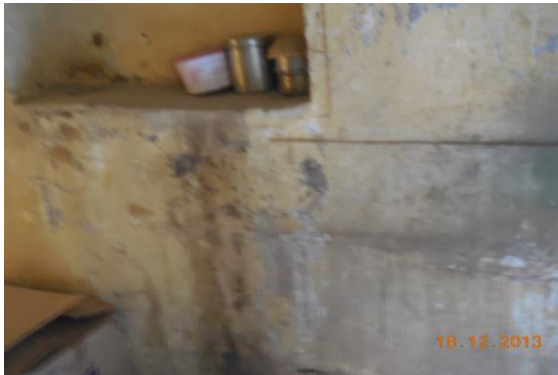
Photo 75

Dampness/Seepage on Wall No. 1 of Passage No.2 of Neel mani Ji Ka Temple, Ground Floor

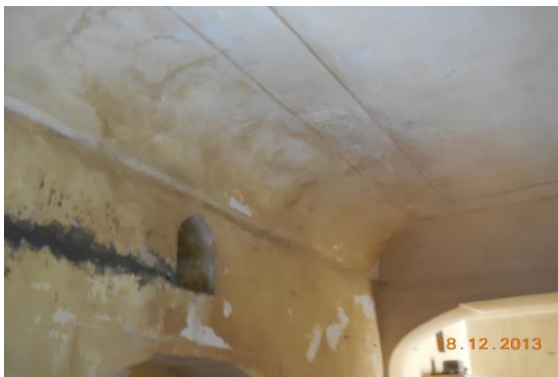
Photo 77

Dampness/Seepage on Wall No. 1 & Roof Shade of Passage No.2 of Neel mani Ji Ka Temple, Ground Floor

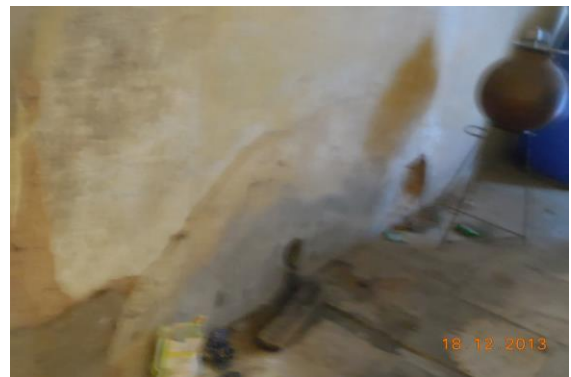
Photo 78

Damaged Portion on Wall No. 2 of Passage No.2 of Neel mani Ji Ka Temple, Ground Floor

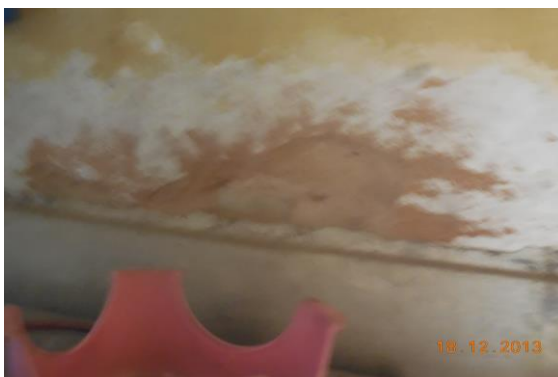
Photo 79

Peeling of Plaster on Wall No. 1 of Passage No.2 of Neel mani Ji Ka Temple, Ground Floor

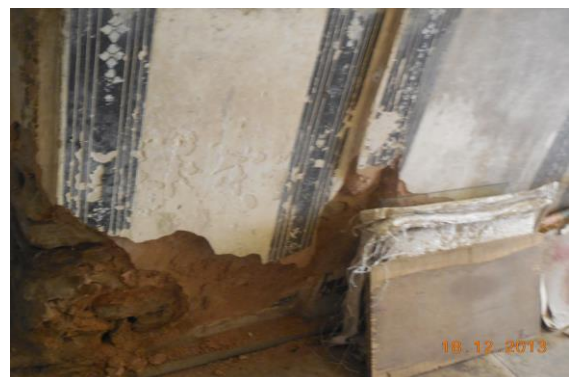
Photo 80

Damaged Portion on Wall No. 2 of Passage No.3 of Neel mani Ji Ka Temple, Ground Floor

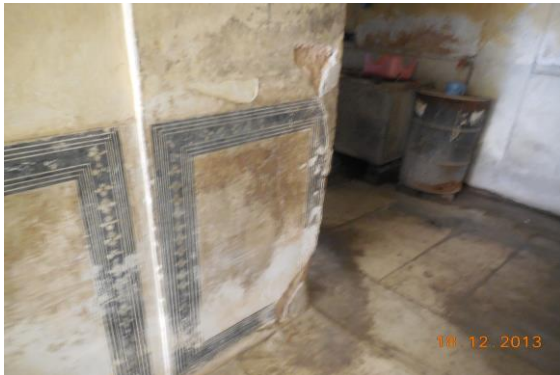
Photo 81

Peeling of Plaster on Wall No. 1 of Passage No.3 of Neel mani Ji Ka Temple, Ground Floor

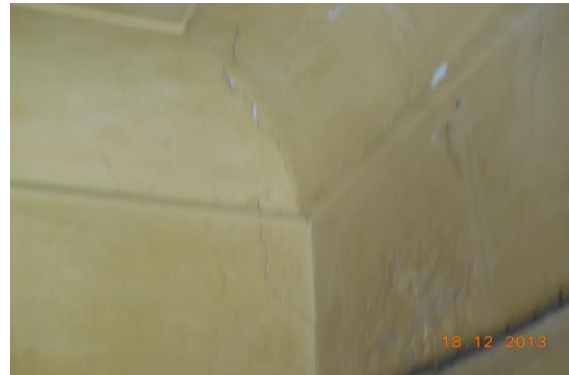
Photo 82

Plaster Crack on Wall No. Roof & 2 of Varanda No.5 of Neel mani Ji Ka Temple, Ground Floor

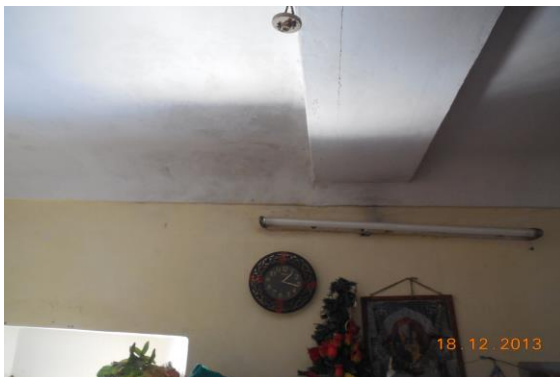
Photo 83

Dampness/Seepage on Roof of Room No. 4 of Neel Mani Ji Ka Temple Ground Floor

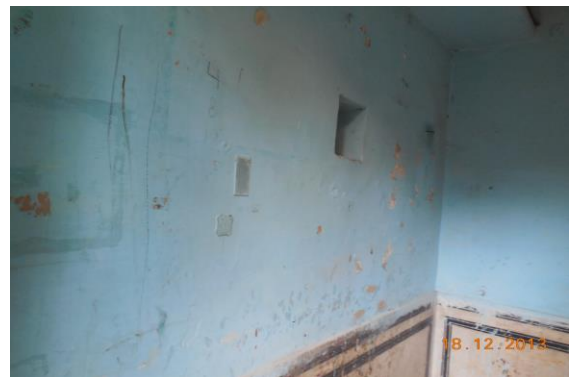
Photo 84

Peeling of Plaster on Wall No. 1 of Varanda No.6 of Neel mani Ji Ka Temple, Ground Floor

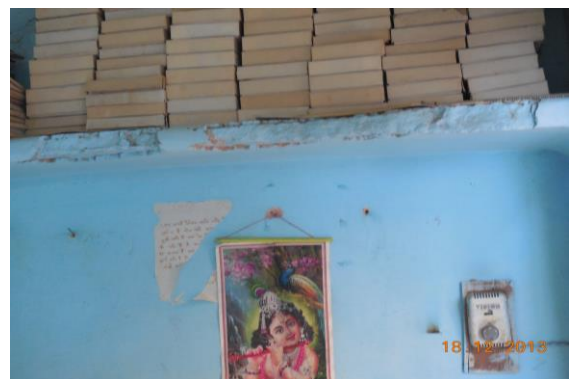
Photo 86

Peeling of Plaster on Roof of Varanda No.6 of Neel mani Ji Ka Temple, Ground Floor

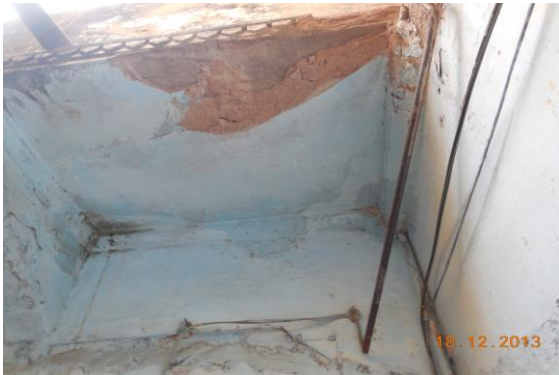
Photo 87

Damaged Portion on Wall No. 2 & Shade of Open Sky Lobby of Neel mani Ji Ka Temple, Ground Floor

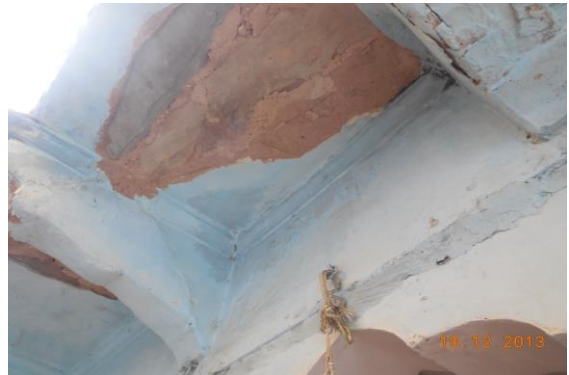
Photo 88

Damaged Portion on Wall No. 2 & Shade of Open Sky Lobby of Neel mani Ji Ka Temple, Ground Floor

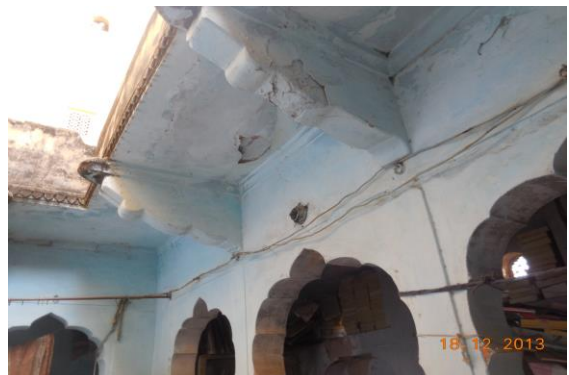
Photo 89

Damaged Portion on Wall No. 2 & Shade of Open Sky Lobby of Neel mani Ji Ka Temple, Ground Floor

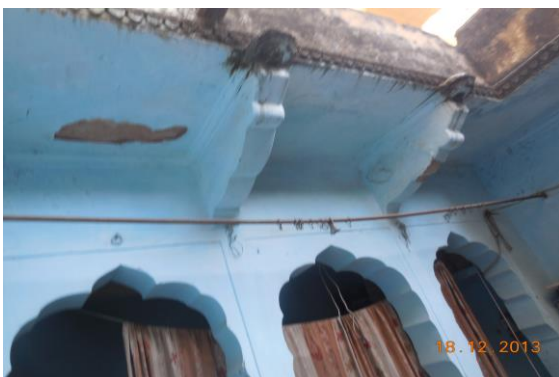
Photo 90

Peeling of Plaster on Wall No. 4 & Shade of Open Sky Lobby of Neel mani Ji Ka Temple, Ground Floor

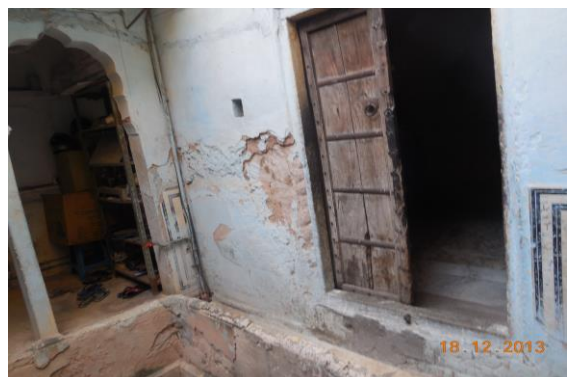
Photo 91

Peeling of Plaster on Wall No. 1 & Shade of Open Sky Lobby of Neel mani Ji Ka Temple, Ground Floor

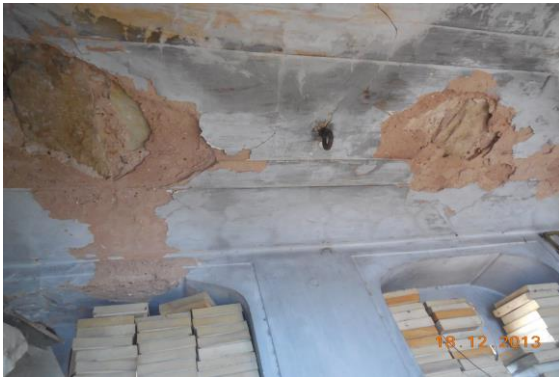
Photo 92

Peeling of Plaster on Wall No. 2 & 3 of Open Sky Lobby of Neel mani Ji Ka Temple, Ground Floor

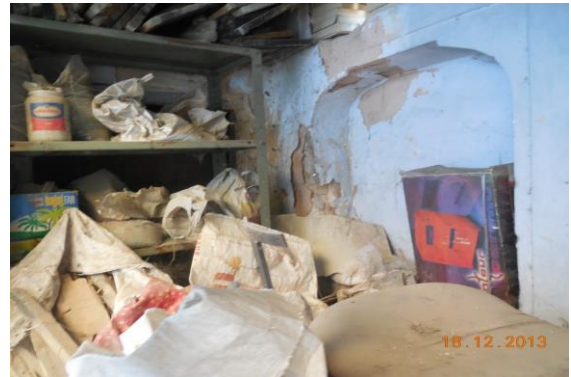
Photo 93

Damaged Portion on Roof of Varanda No.7 of Neel mani Ji Ka Temple, Ground Floor

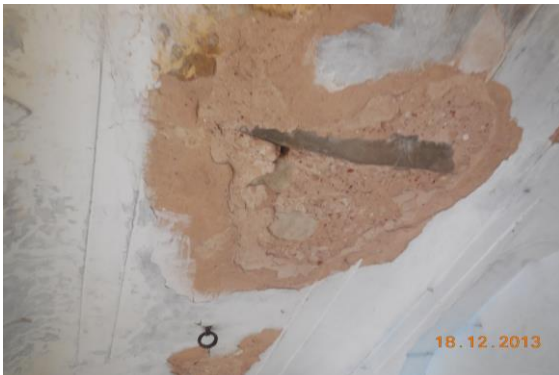
Photo 94

Damaged Portion on Wall No. 1 & 4 of Varanda No.7 of Neel mani Ji Ka Temple, Ground Floor

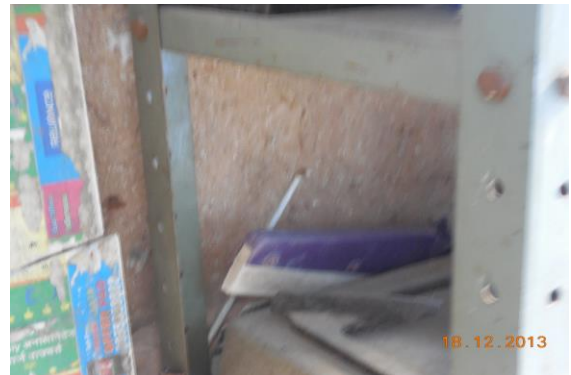
Photo 95

Damaged Portion on Roof of Varanda No.8 of Neel mani Ji Ka Temple, Ground Floor

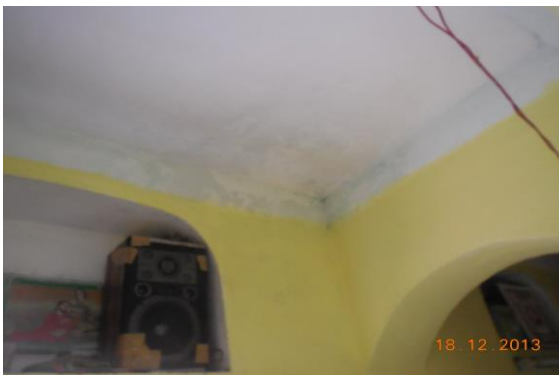
Photo 96

Peeling of Plaster on Wall No. 4 of Varanda No.8 of Neel mani Ji Ka Temple, Ground Floor

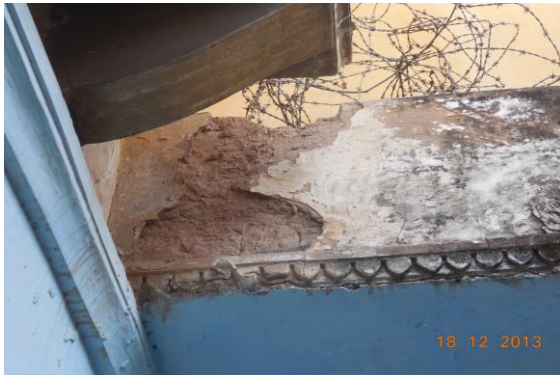
Photo 98

Peeling of Plaster on Column of Room No. 5 of Neel Mani Ji Ka Temple Ground Floor

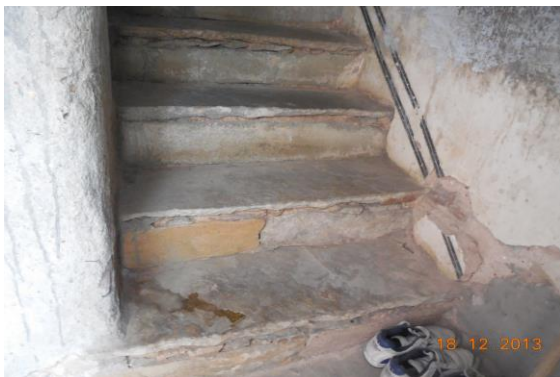
Photo 100

Peeling of Plaster on Wall No. 4 of Staircase Ground Floor To First Floor of Neel mani Ji Ka Temple, Ground Floor

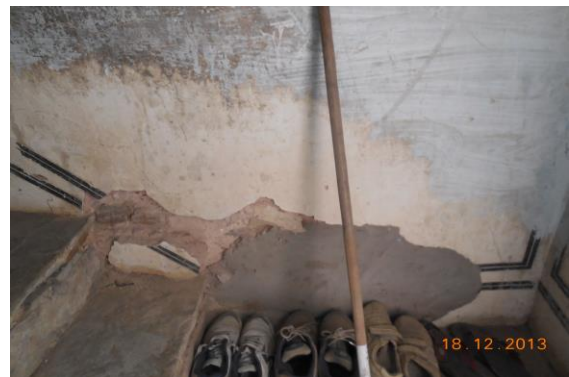
Photo 101

Damaged Portion on Steps of Staircase Ground Floor To First Floor of Neel mani Ji Ka Temple, Ground Floor

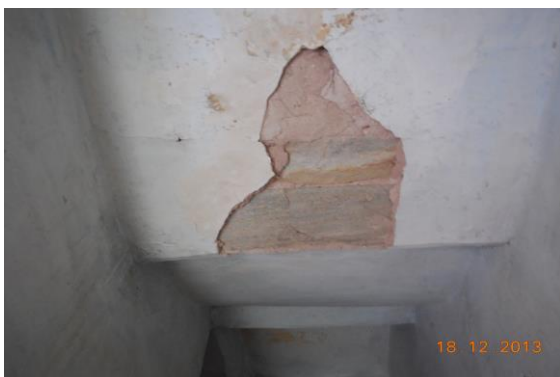
Photo 102

Damaged Portion on Wall No. 2 of Staircase Ground Floor To First Floor of Neel mani Ji Ka Temple, Ground Floor

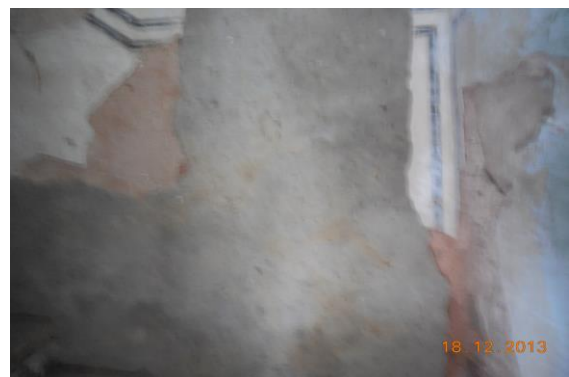
Photo 103

Peeling of Plaster on Roof of Staircase Ground Floor To First Floor of Neel mani Ji Ka Temple, Ground Floor

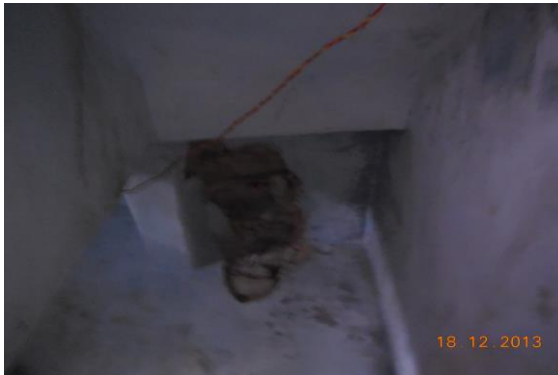
Photo 104

Peeling of Plaster of Staircase Ground Floor To First Floor of Neel mani Ji Ka Temple, Ground Floor

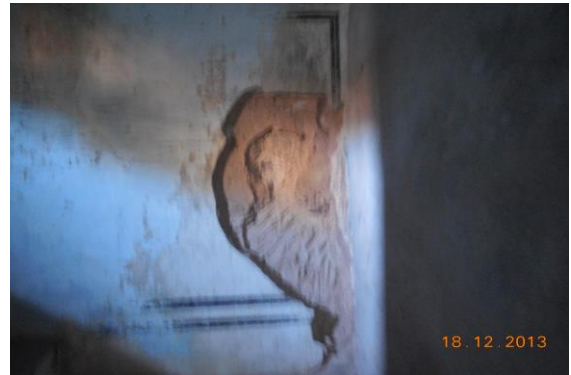
Photo 105

Damaged Portion on Roof of Staircase Ground Floor To First Floor of Neel mani Ji Ka Temple, Ground Floor

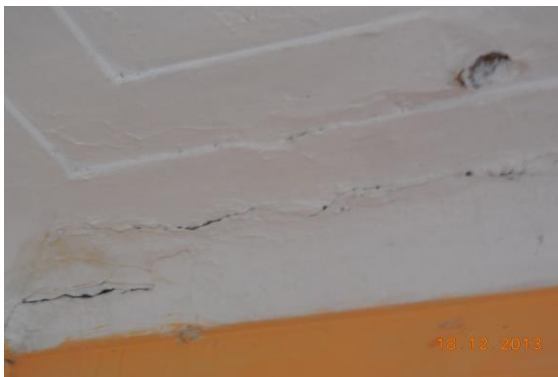
Photo 106

Damaged Portion on Wall No. 4 of Staircase Ground Floor To First Floor of Neel mani Ji Ka Temple, Ground Floor

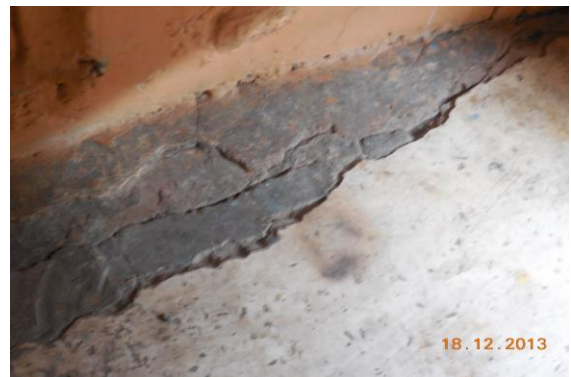
Photo 107

Plaster Crack on Roof of Staircase Ground Floor To First Floor of Neel mani Ji Ka Temple, Ground Floor

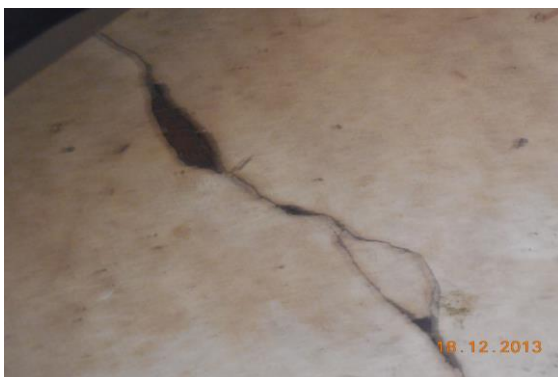
Photo 108

Plaster Crack on Floor of Room No. 1 of Staircase Ground Floor To First Floor Neel mani Ji Ka Temple, Ground Floor

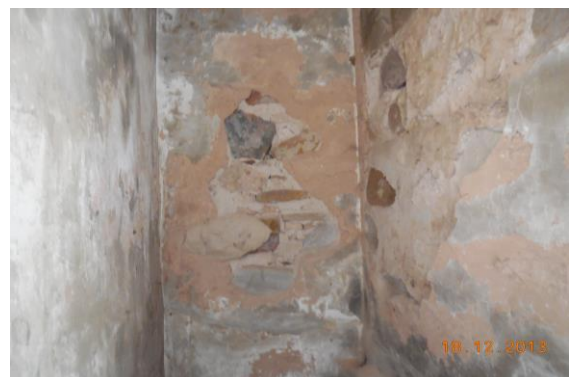
Photo 109

Plaster Crack on Floor of Room No. 1 of Staircase Ground Floor To First Floor Neel mani Ji Ka Temple, Ground Floor
