Pre Building Condition Survey Report

Name and Address of Structure :	Choti Chopar to Badi Chopar (UP Line)
---------------------------------	---------------------------------------

Name of the Project	Contract JMRC-UG1B “Design and Construction of Tunnel between Chandpole and Badi Chouper and reverse line by Shield TBM, Underground Metro Stations at Choti Chouper and Badi Chouper by Cut and Cover Methods on East West Corridor of Jaipur Metro Rail Corporation Limited .”	
Owner :

Shoping Complex - Shop No. 169-188
Tripolia Bazar
Jaipur
Unique ID: CC BC UP 0001

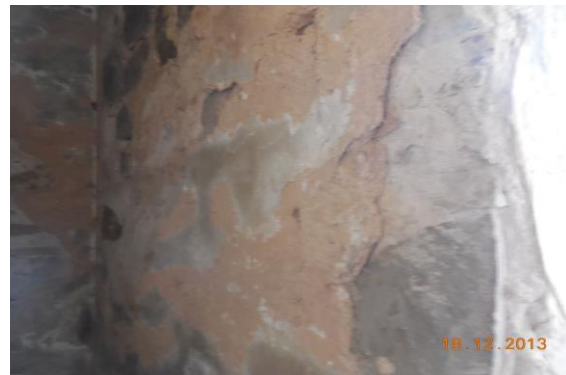
Photo 111

Damaged Portion on Roof of Staircase First Floor To Second Floor of Neel mani Ji Ka Temple, First Floor

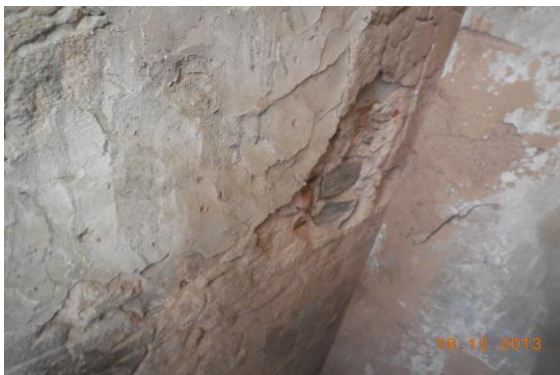
Photo 112

Damaged Portion on Wall No. 1 of Staircase First Floor To Second Floor of Neel mani Ji Ka Temple, First Floor

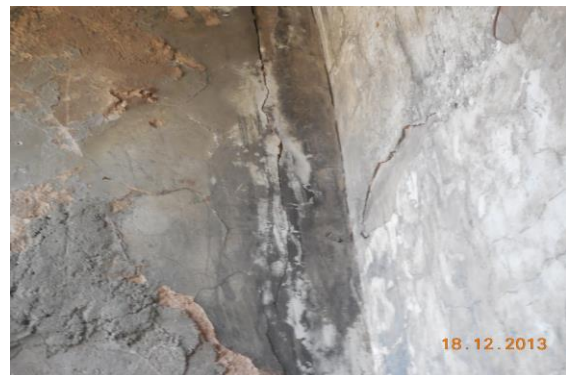
Photo 113

Damaged Portion on Wall No. 2 of Staircase First Floor To Second Floor of Neel mani Ji Ka Temple, First Floor

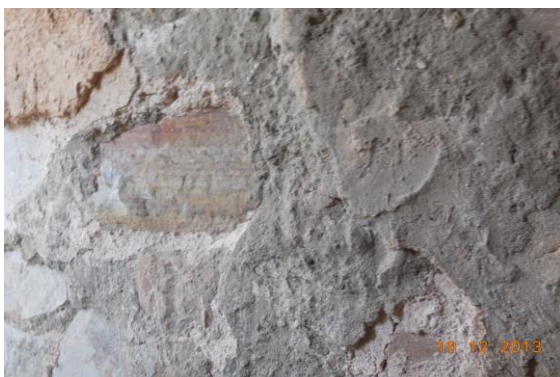
Photo 114

Damaged Portion on Wall No. 4 of Staircase First Floor To Second Floor of Neel mani Ji Ka Temple, First Floor

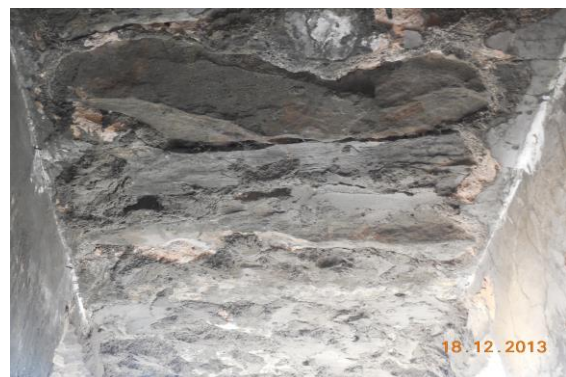
Photo 115

Peeling of Plaster on Wall No. 2 of Staircase First Floor To Second Floor of Neel mani Ji Ka Temple, First Floor

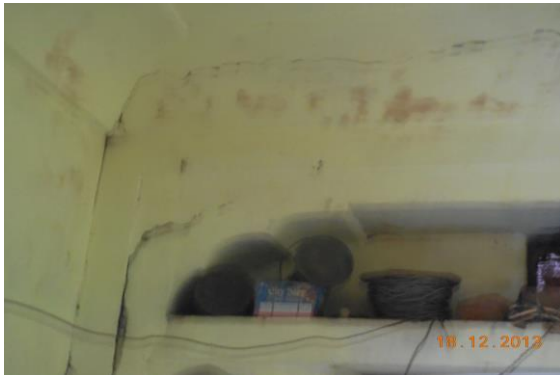
Photo 116

Peeling of Plaster on Roof of Staircase First Floor To Second Floor of Neel mani Ji Ka Temple, First Floor

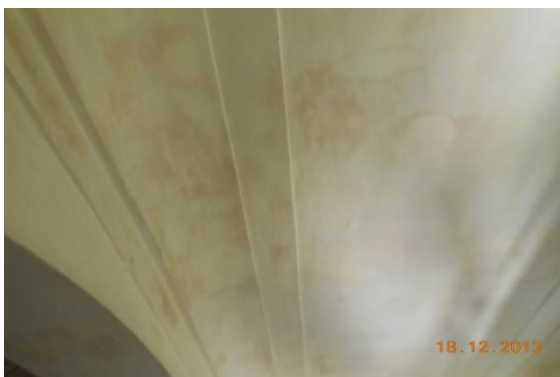
Photo 120

Peeling of Plaster on Floor of Room No. 2 of Neel mani Ji Ka Temple First Floor

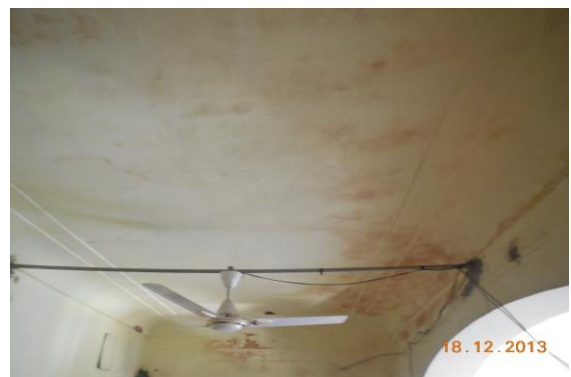
Photo 121

Dampness/Seepage on Roof of Room No. 2 of Neel mani Ji Ka Temple First Floor

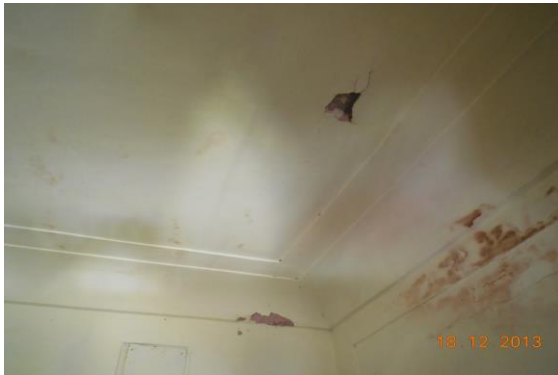
Photo 122

Dampness/Seepage on Roof of Room No. 2 of Neel mani Ji Ka Temple First Floor

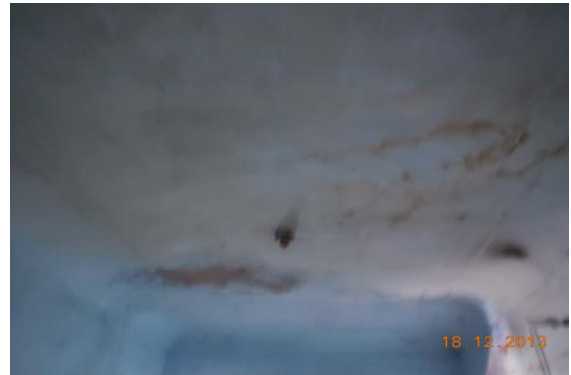
Photo 123

Peeling of Plaster on Roof of Room No. 2 of Neel mani Ji Ka Temple First Floor

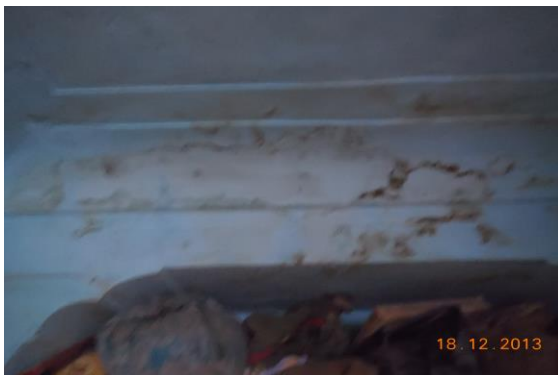
Photo 124

Dampness/Seepage on Roof of Room No. 3 of Neel mani Ji Ka Temple First Floor

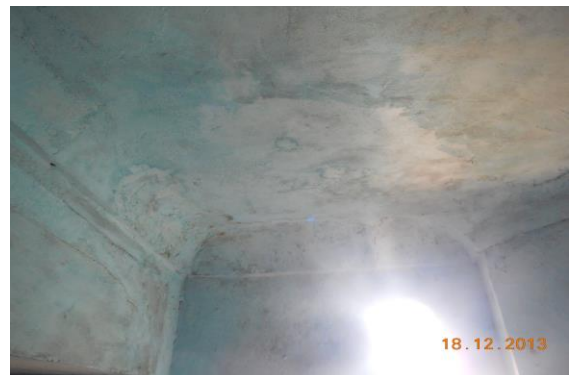
Photo 125

Peeling of Plaster on Wall No. 3 & Roof of Room No. 3 of Neel mani Ji Ka Temple First Floor

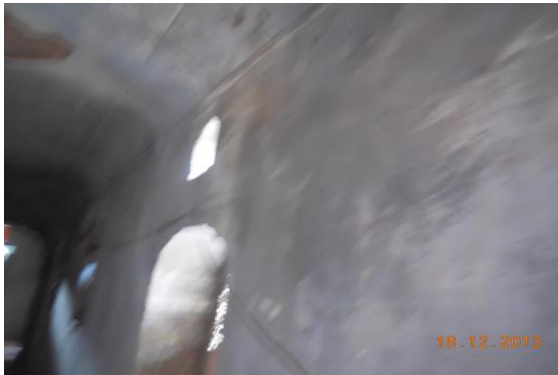
Photo 129
Dampness/Seepage on Wall No. 2 of Gallery No.3 of Neel mani Ji Ka Temple, First Floor

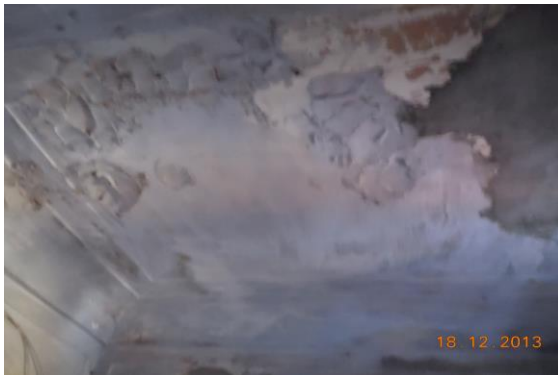
Photo 131
Peeling of Plaster on Roof of Gallery No.3 of Neel mani Ji Ka Temple, First Floor

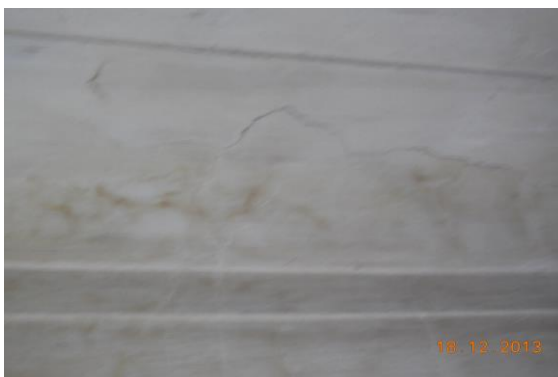
Photo 133
Plaster Crack on Roof of Gallery No.4 of Neel mani Ji Ka Temple, First Floor

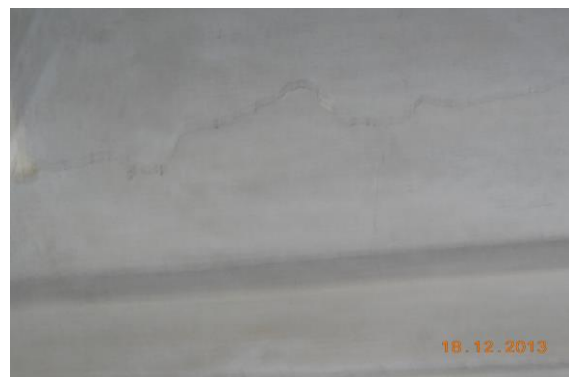
Photo 134
Plaster Crack on Roof of Gallery No.4 of Neel mani Ji Ka Temple, First Floor

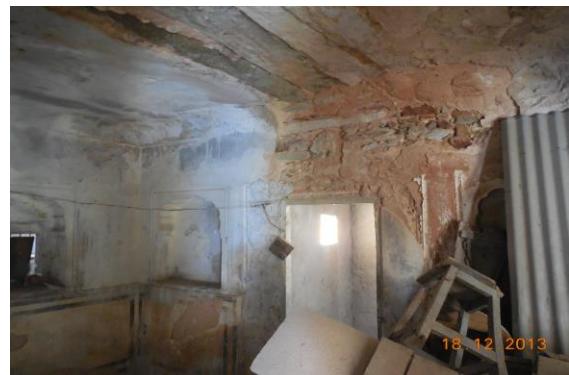
Photo 138

Damaged Portion on Wall No. 4 & Roof of Varanda of Neel mani Ji Ka Temple, First Floor

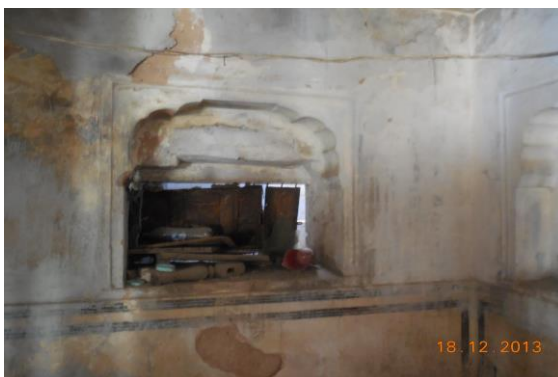
Photo 139

Peeling of Plaster on Wall No. 1 of Varanda of Neel mani Ji Ka Temple, First Floor

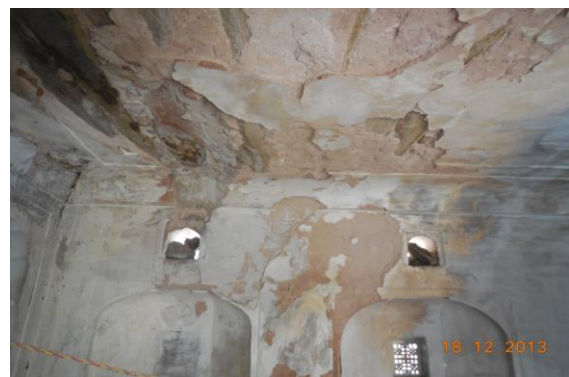
Photo 140

Damaged Portion on Wall No. 4 & Roof of Varanda of Neel mani Ji Ka Temple, First Floor

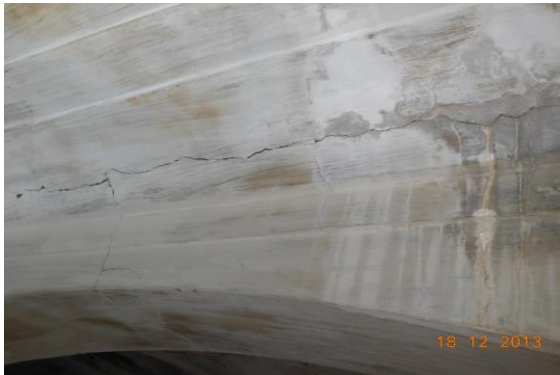
Photo 141

Plaster Crack on Roof of Varanda of Neel mani Ji Ka Temple, First Floor

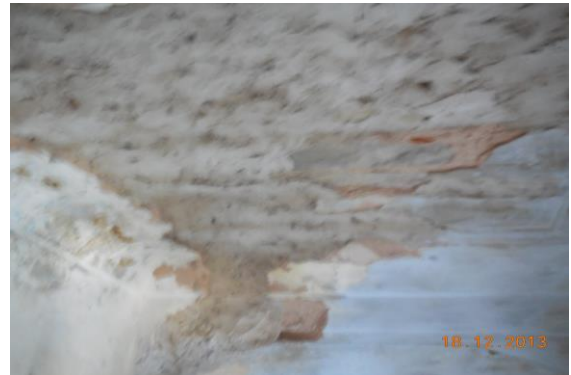
Photo 142

Damaged Portion on Wall No. 2 & Roof of Varanda of Neel mani Ji Ka Temple, First Floor

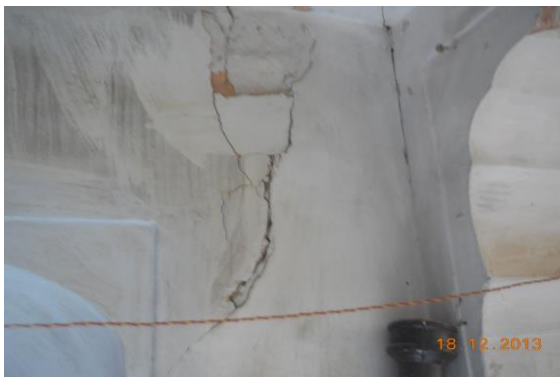
Photo 143

Damaged Portion on Wall No. 3 of Varanda of Neel mani Ji Ka Temple, First Floor

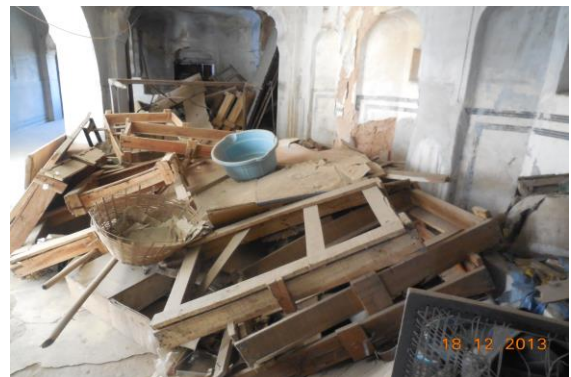
Photo 144

Peeling of Plaster on Floor of Varanda of Neel mani Ji Ka Temple, First Floor

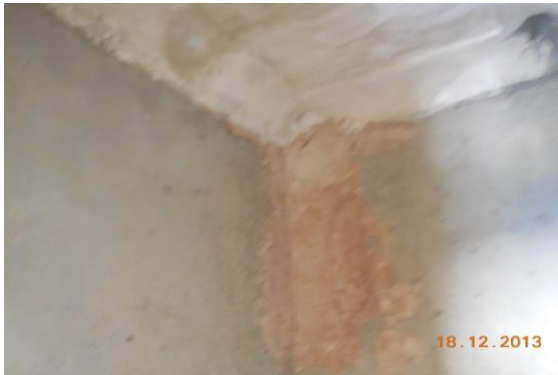
Photo 147

Peeling of Plaster of Toilet No. 1 of Neel mani Ji Ka Temple Terrace

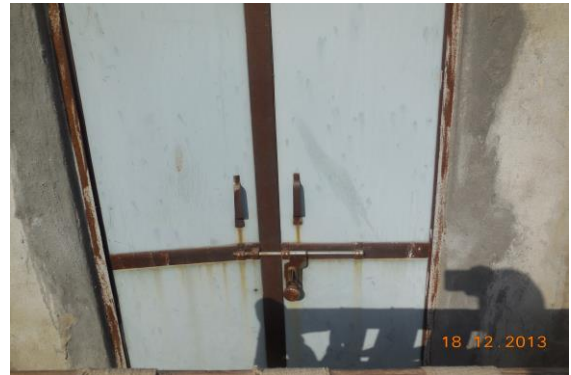
Photo 148

Damaged Portion on Wall No. 4 of Open sky of Neel mani Ji Ka Temple, Terrace

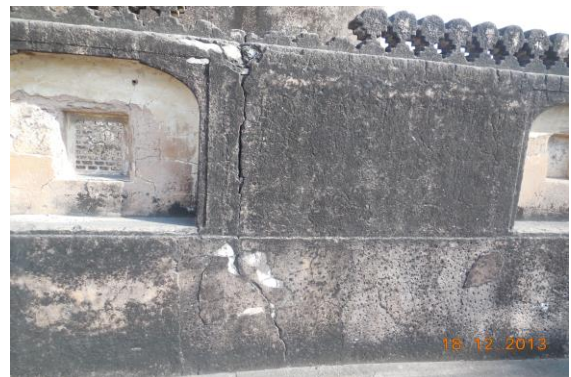
Photo 150

Damaged Portion on Wall No. 4 of Open sky of Neel mani Ji Ka Temple, Terrace

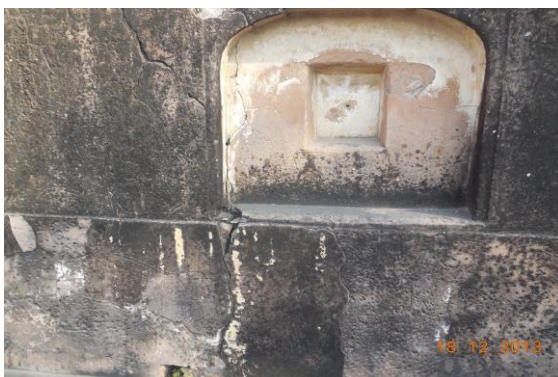
Photo 151

Damaged Portion on Wall No. 4 of Open sky of Neel mani Ji Ka Temple, Terrace

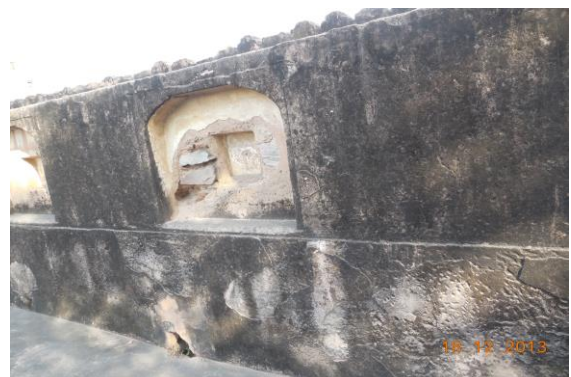
Photo 152

Damaged Portion on Wall No. 2 of Open sky of Neel mani Ji Ka Temple, Terrace

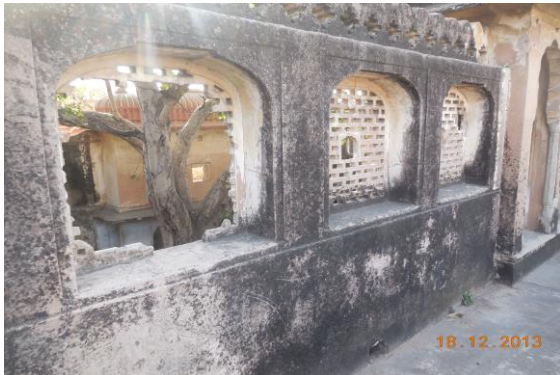
Photo 153

Damaged Portion on Roof of Tomb of Neel mani Ji Ka Temple, Terrace

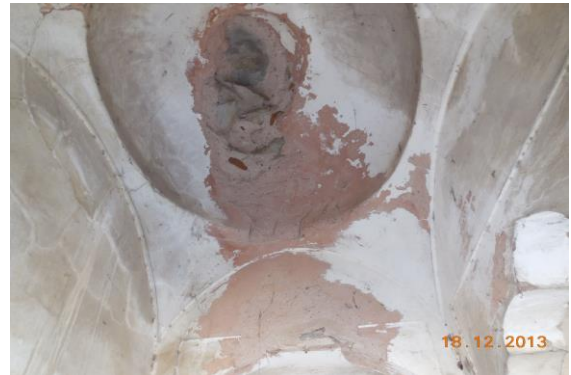
Photo 154

Damaged Portion on Roof of Tomb of Neel mani Ji Ka Temple, Terrace

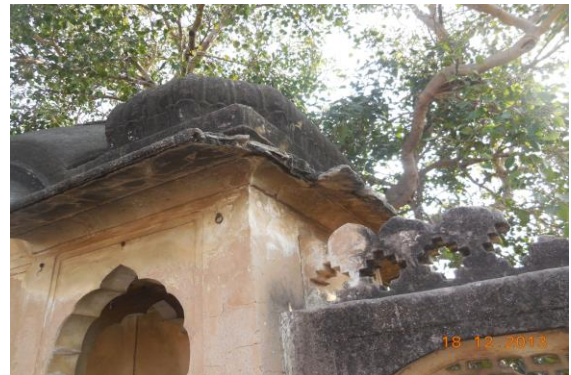
Photo 156

Damaged Portion on Frontside Parapet wall of Tomb No.1 of Neel mani Ji Ka Temple, Terrace

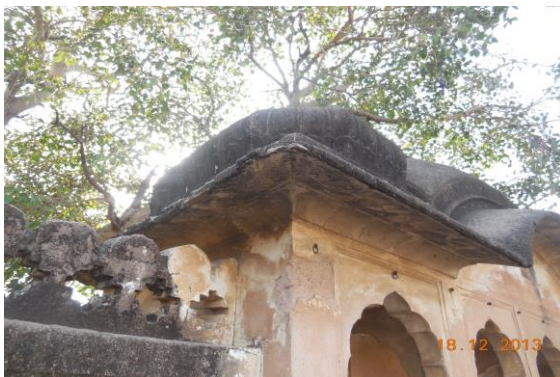
Photo 157

Damaged Portion on Frontside Parapet wall of Tomb No.1 of Neel mani Ji Ka Temple, Terrace

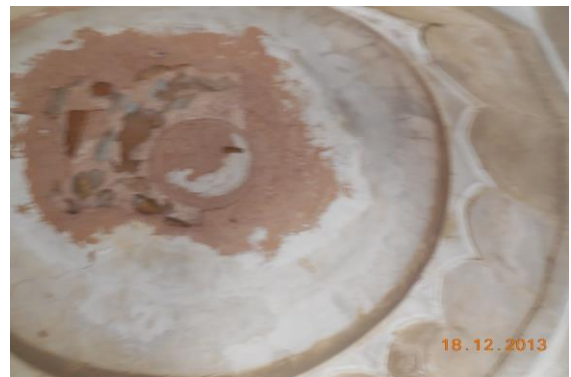
Photo 158

Damaged Portion on Roof of Tomb No.1 of Neel mani Ji Ka Temple, Terrace

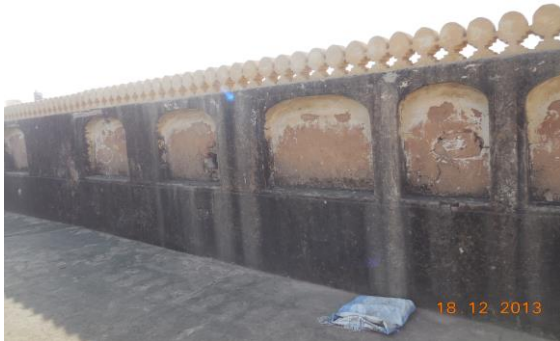
Photo 159

Peeling of Plaster on Wall No. 2 of Tomb No.1 of Neel mani Ji Ka Temple, Terrace

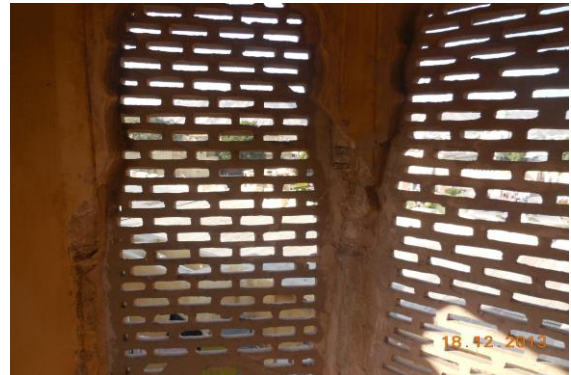
Photo 160

Peeling of Plaster of Tomb No.6 of Neel mani Ji Ka Temple, Terrace

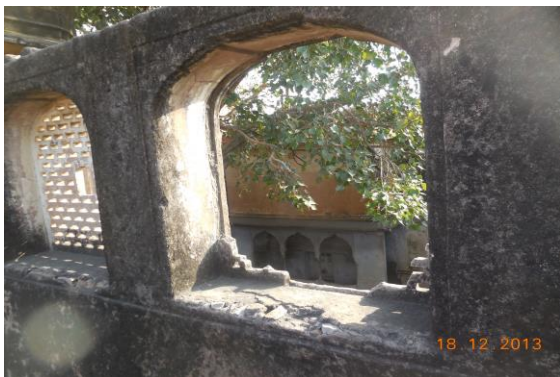
Photo 161

Damaged Portion on Wall No. 2 of Tomb No.1 of Neel mani Ji Ka Temple, Terrace

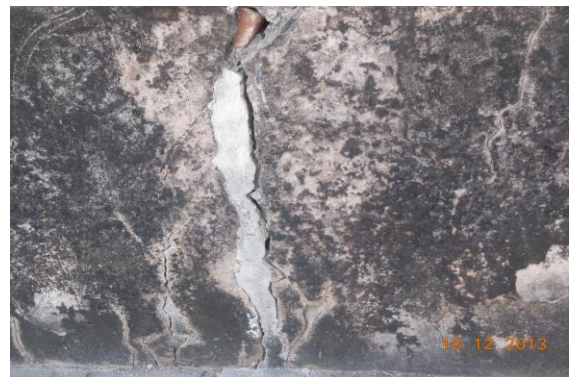
Photo 162

Damaged Portion on Wall No. 2 of Tomb No.1 of Neel mani Ji Ka Temple, Terrace

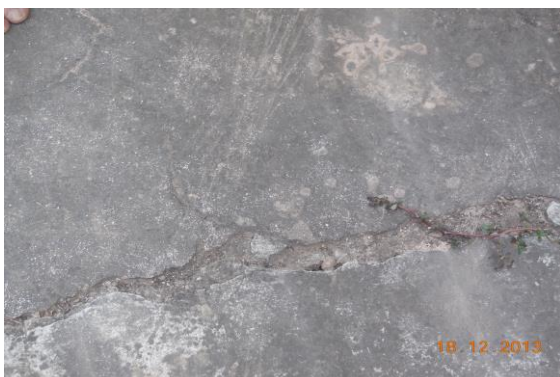
Photo 163

Damaged Portion on Floor of Tomb No.1 of Neel mani Ji Ka Temple, Terrace

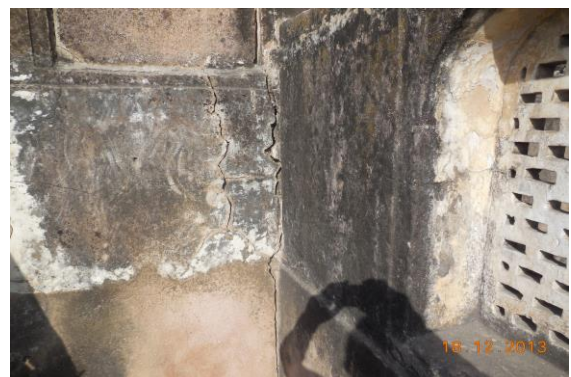
Photo 164

Damaged Portion on Wall No. 3 of Open area of Neel mani Ji Ka Temple, Terrace

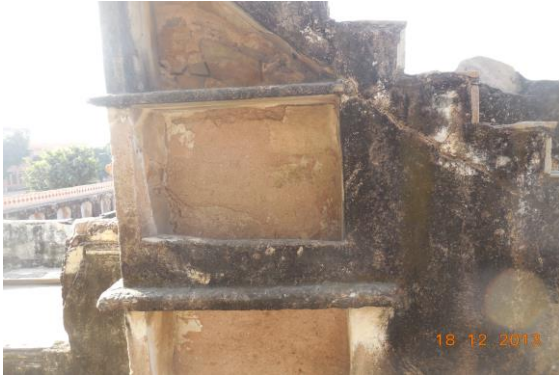
Photo 165

Damaged Portion on Wall No. 2 Below stairs of Open area of Neel mani Ji Ka Temple, Terrace

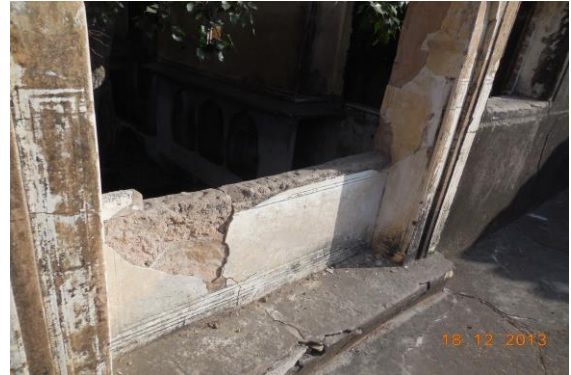
Photo 166

Damaged Portion on Wall No. 1 Below Stairs of Open area of Neel mani Ji Ka Temple, Terrace

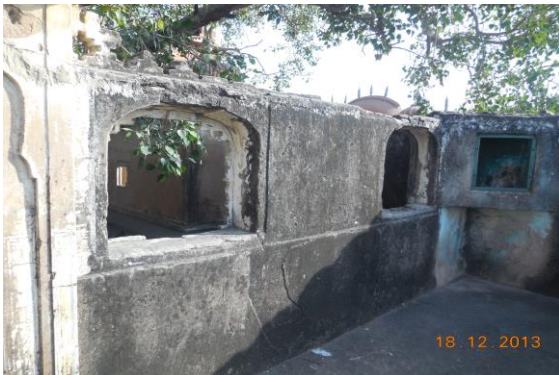
Photo 167

Damaged Portion on Wall No. 1 Window of Open area of Neel mani Ji Ka Temple, Terrace

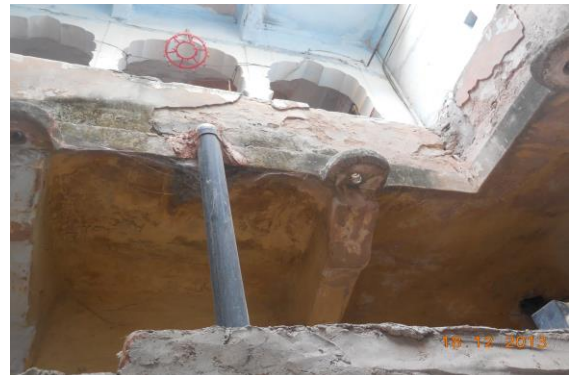
Photo 168

Peeling of Plaster on Wall No. 1 Parapet wall of Open area of Neel mani Ji Ka Temple, Lower Ground Floor

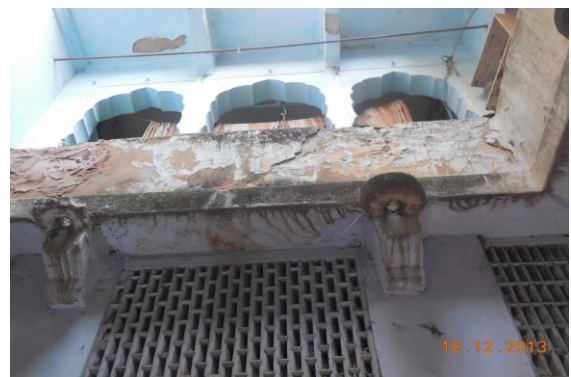
Photo 169

Peeling of Plaster on Wall No. 4 Parapet wall of Open area of Neel mani Ji Ka Temple, Lower Ground Floor

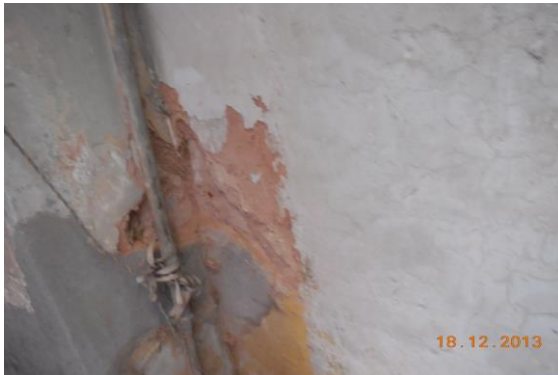
Photo 170

Peeling of Plaster on Wall No. 2 Parapet wall of Open area of Neel mani Ji Ka Temple, Lower Ground Floor

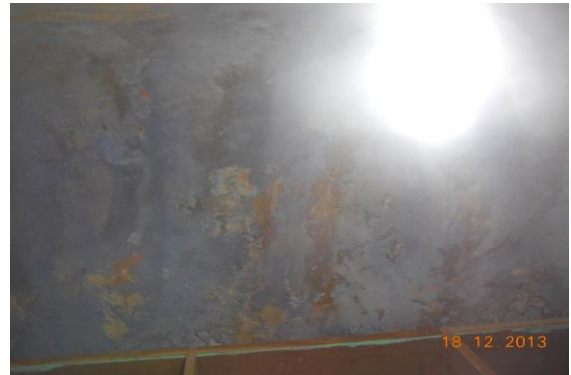
Photo 171

Peeling of Plaster on Wall No. 1 & 3 of Open area of Neel mani Ji Ka Temple, Lower Ground Floor

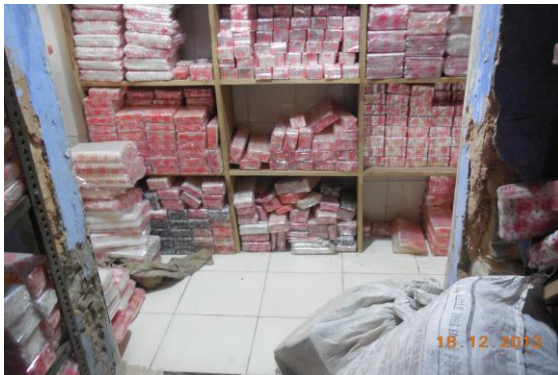
Photo 172

Dampness/Seepage on Roof of Store of Neel mani Ji Ka Temple, Lower Ground Floor

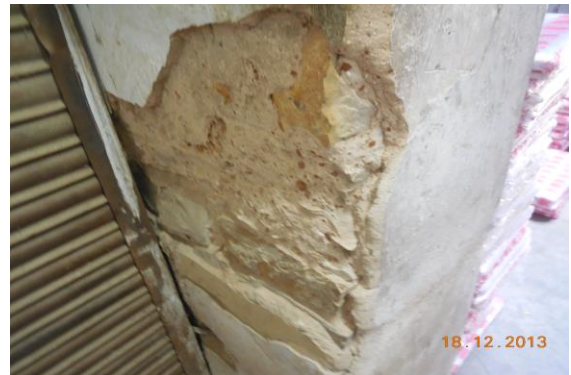
Photo 173

Damaged Portion on Wall No. 4 of Store of Neel mani Ji Ka Temple, Lower Ground Floor

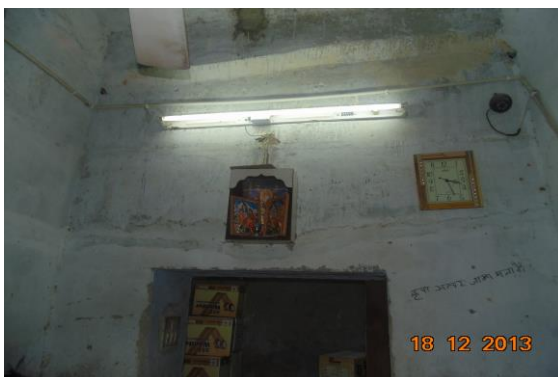
Photo 174

Damaged Portion on Wall No. 3 of Varanda of Neel mani Ji Ka Temple, Lower Ground Floor

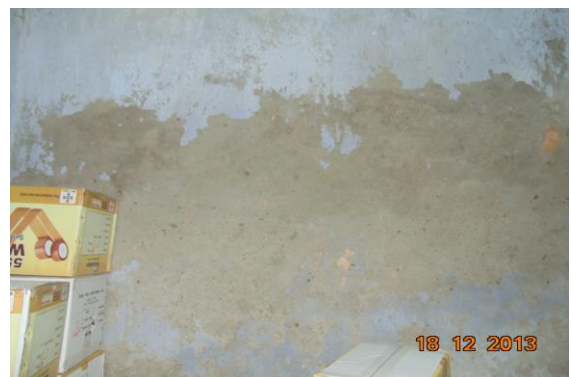
Photo 175

Damaged Portion on Wall No. 3 of Room No. 1 of Varanda Neel mani Ji Ka Temple, Lower Ground Floor

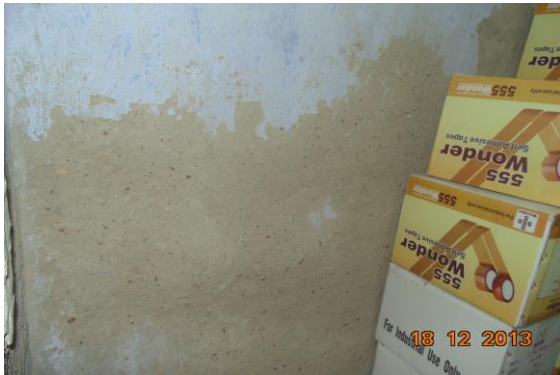
Photo 176

Dampness/Seepage on Wall No. 1 of Room No. 1 of Varanda Neel mani Ji Ka Temple, Lower Ground Floor

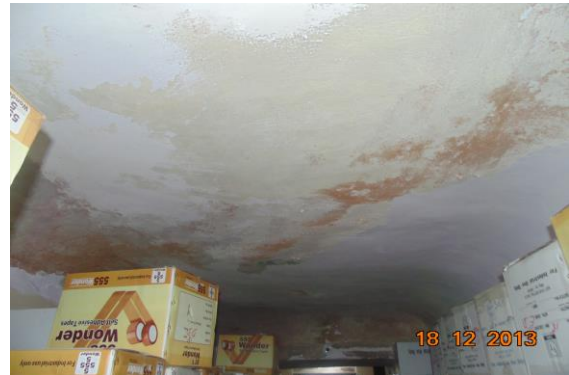
Photo 177

Dampness/Seepage on Wall No. 4 of Room No. 1 of Varanda Neel mani Ji Ka Temple, Lower Ground Floor

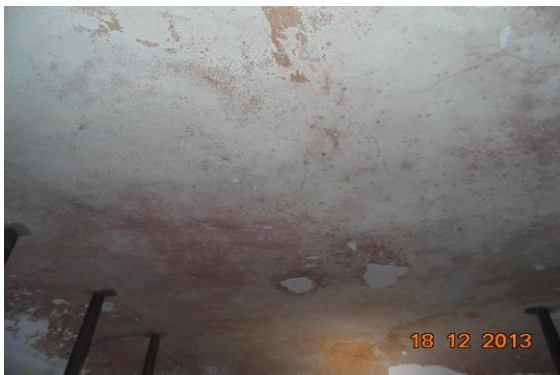
Photo 178

Dampness/Seepage on Part B of Gallery No.2 of Neel mani Ji Ka Temple, Lower Ground Floor

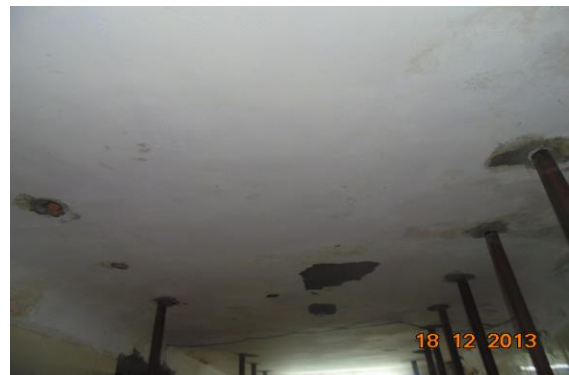
Photo 179

Dampness/Seepage on Roof of Gallery No.2 of Neel mani Ji Ka Temple, Lower Ground Floor

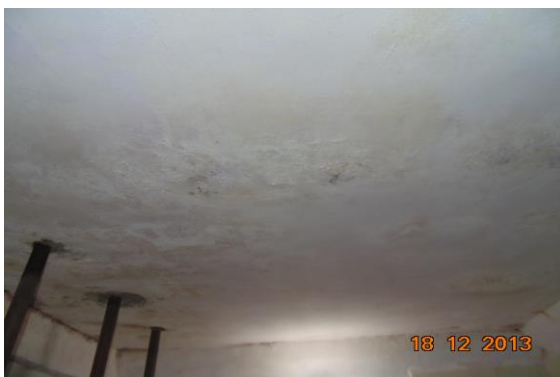
Photo 180

Dampness/Seepage on Roof of Gallery No.3 of Neel mani Ji Ka Temple, Lower Ground Floor

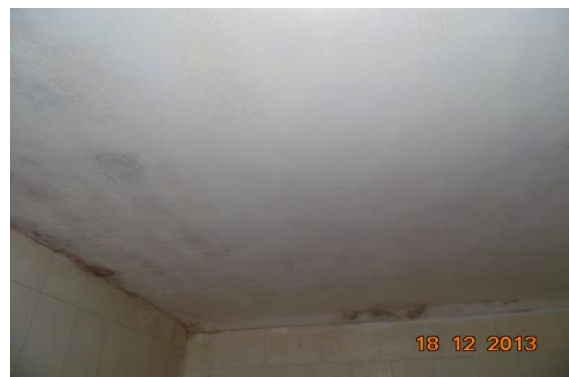
Photo 181

Dampness/Seepage on Roof of Gallery No.4 of Neel mani Ji Ka Temple, Lower Ground Floor

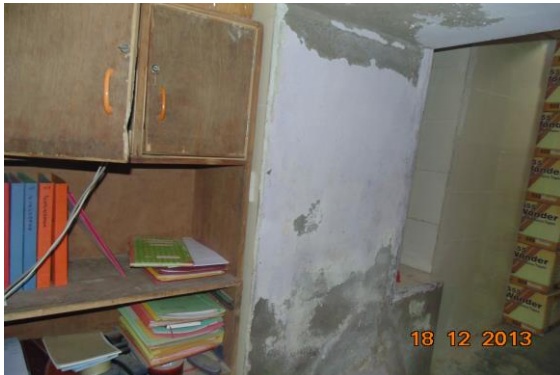
Photo 182

Dampness/Seepage on Roof of Gallery No.5 of Neel mani Ji Ka Temple, Lower Ground Floor

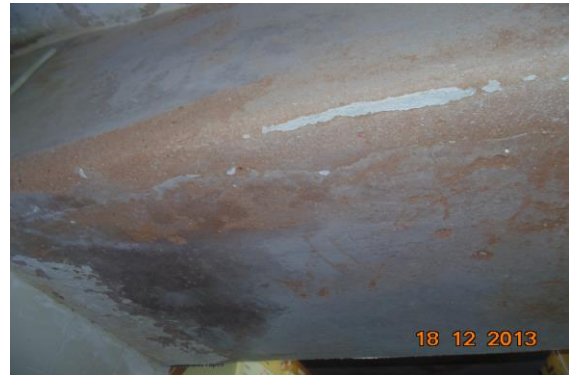
Photo 183

Dampness/Seepage on Wall No. 1 & Roof of Gallery of Neel mani Ji Ka Temple, Lower Ground Floor

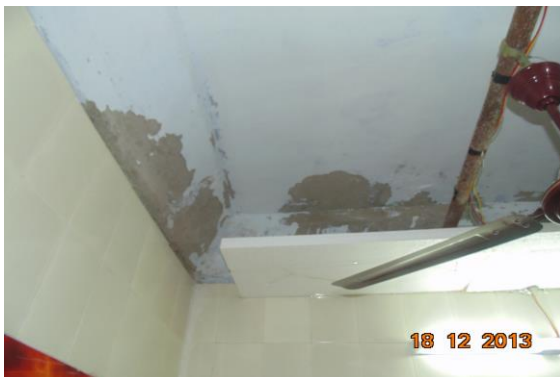
Photo 184

Dampness/Seepage on Roof of Part - I Gallery of Neel mani Ji Ka Temple, Lower Ground Floor

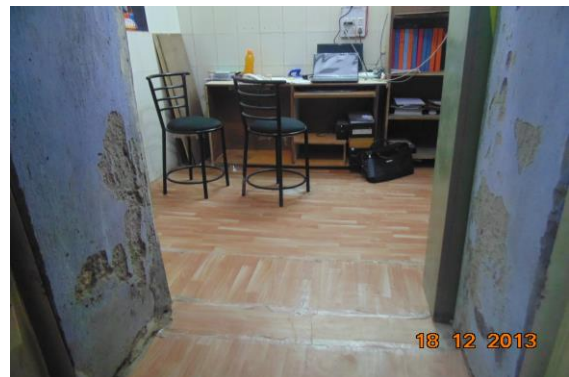
Photo 185

Peeling of Plaster on Roof of Room No. 1 of Neel Mani Ji Ka Temple Lower Ground Floor

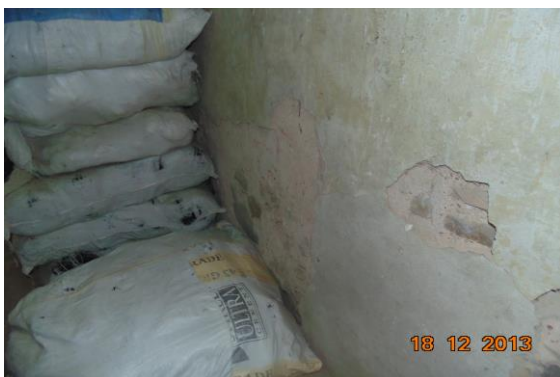
Photo 186

Peeling of Plaster on Entry Gate of Room No. 1 of Neel Mani Ji Ka Temple Lower Ground Floor

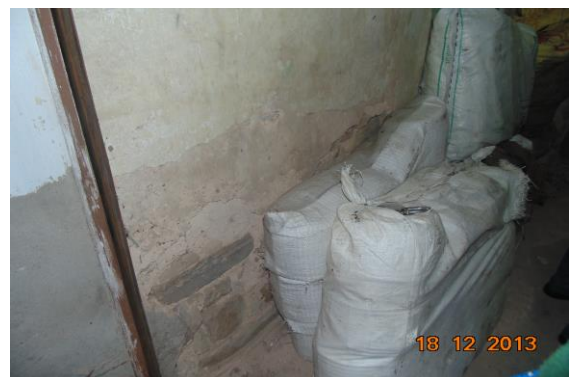
Photo 187

Peeling of Plaster on Wall No. 2 of Store No.2 of Neel mani Ji Ka Temple, Lower Ground Floor

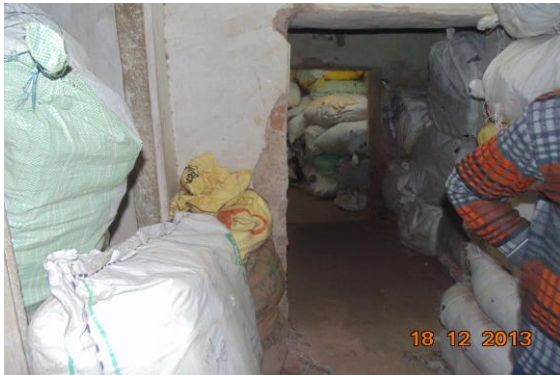
Photo 188

Peeling of Plaster on Wall No. 1 of Store No.2 of Neel mani Ji Ka Temple, Lower Ground Floor

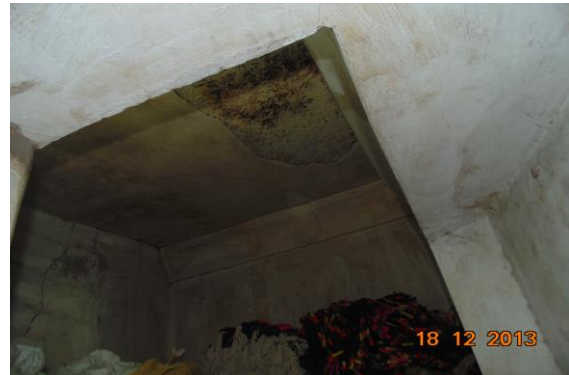
Photo 189

Damaged Portion on Wall No. 4 of Store No.2 of Neel mani Ji Ka Temple, Lower Ground Floor

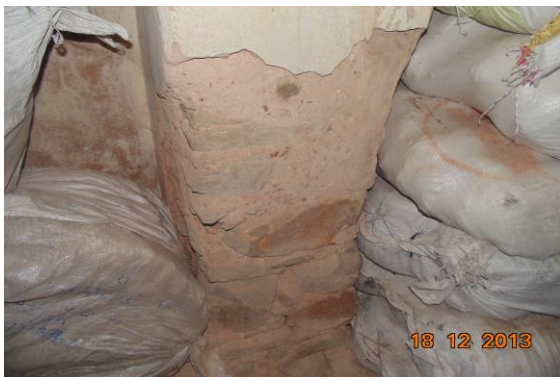
Photo 190

Damaged Portion on Roof of Room No. 2 of Neel Mani Ji Ka Temple Lower Ground Floor

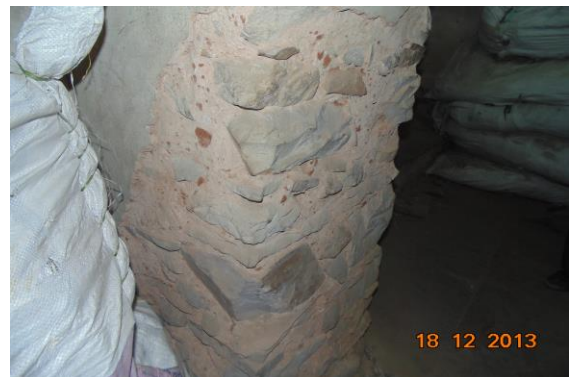
Photo 191

Damaged Portion on Wall No. 2 of Passage No.2 of Neel mani Ji Ka Temple, Basement

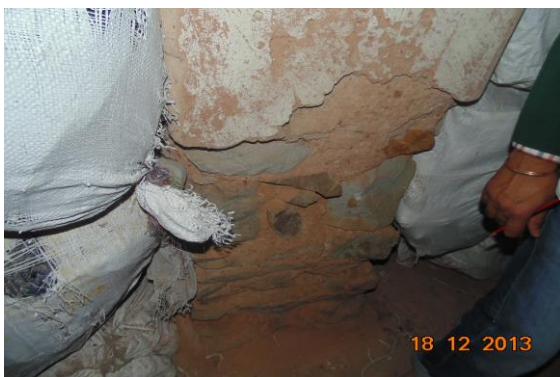
Photo 192

Damaged Portion on Wall No. 1 of Passage No.2 of Neel mani Ji Ka Temple, Basement

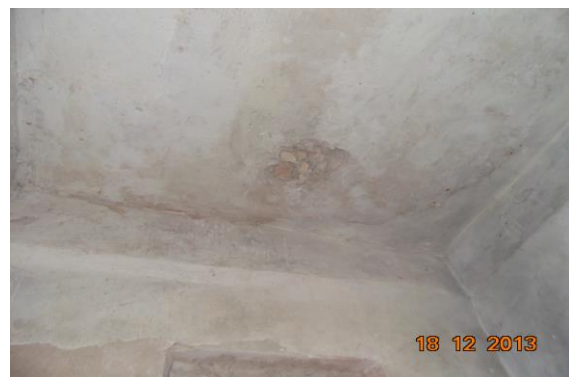
Photo 193

Damaged Portion on Right-side of Passage No.2 of Neel mani Ji Ka Temple, Basement

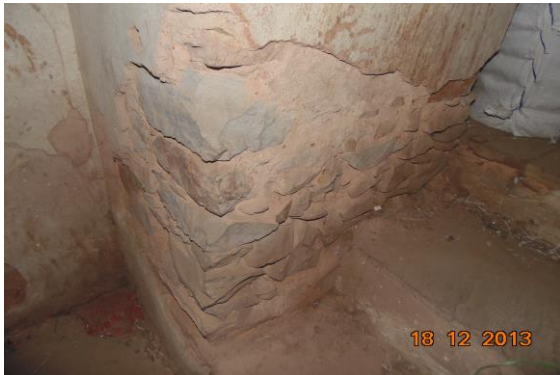
Photo 194

Peeling of Plaster on Roof of Gallery Room of Neel mani Ji Ka Temple, Basement

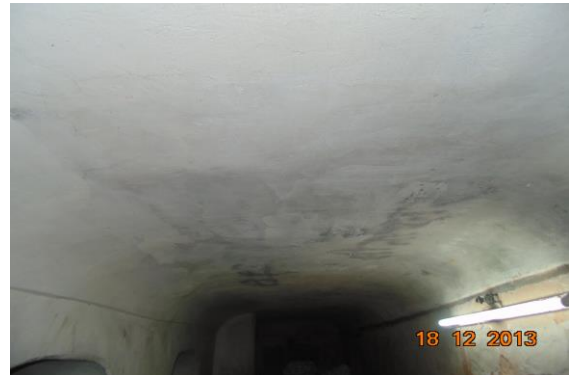
Photo 195

Peeling of Plaster on Roof of Gallery Room of Neel mani Ji Ka Temple, Basement

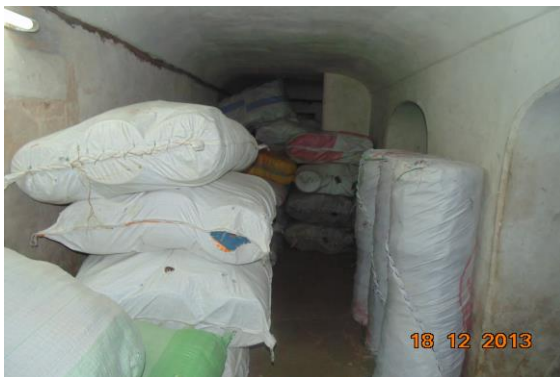
Photo 196

Peeling of Plaster on Wall No. 4 of Part- K of Neel mani Ji Ka Temple, Basement

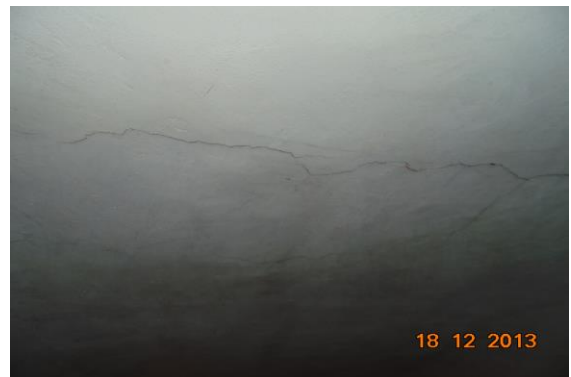
Photo 197

Dampness/Seepage on Roof of Part- K of Neel mani Ji Ka Temple, Basement

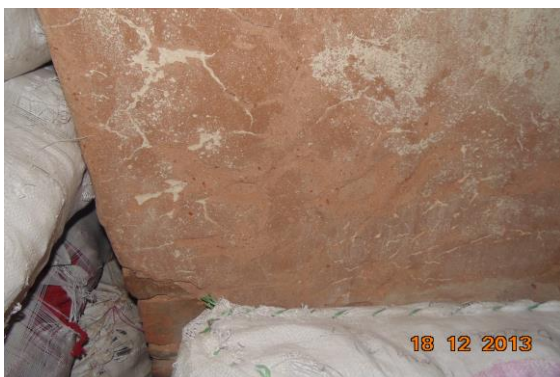
Photo 198

Damaged Portion on Floor of Part- K of Neel mani Ji Ka Temple, Basement

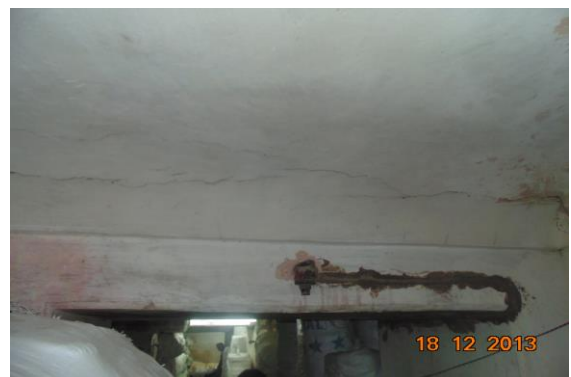
Photo 199

Plaster Crack on Roof of Part- K of Neel mani Ji Ka Temple, Basement

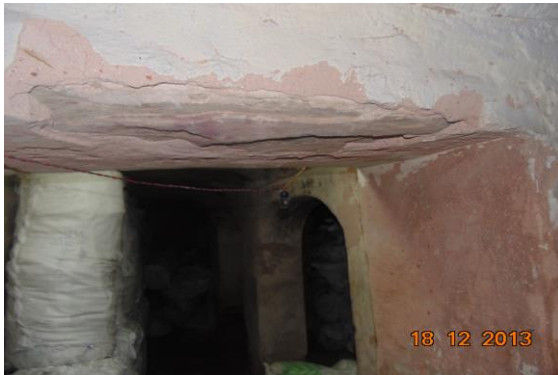
Photo 200

Peeling of Plaster on Entry Gate of Part-L of Neel mani Ji Ka Temple, Basement

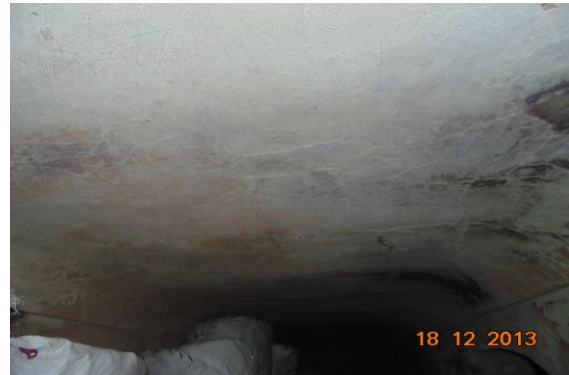
Photo 201
Peeling of Plaster on Roof of Part- M of Neel mani Ji Ka Temple,
Basement

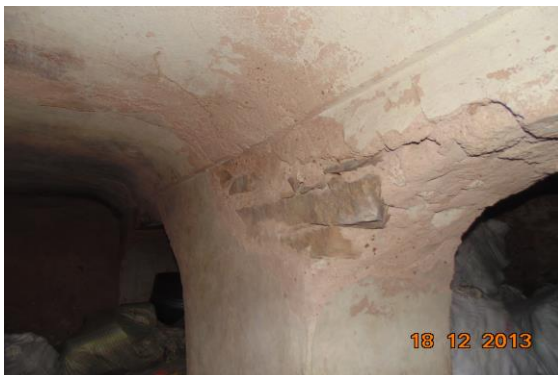
Photo 202
Peeling of Plaster on Roof of Part- N of Neel mani Ji Ka Temple,
Basement

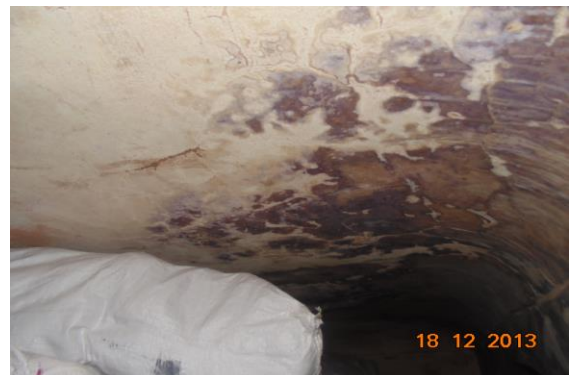
Photo 203
Peeling of Plaster on Roof of Part- N of Neel mani Ji Ka Temple,
Basement

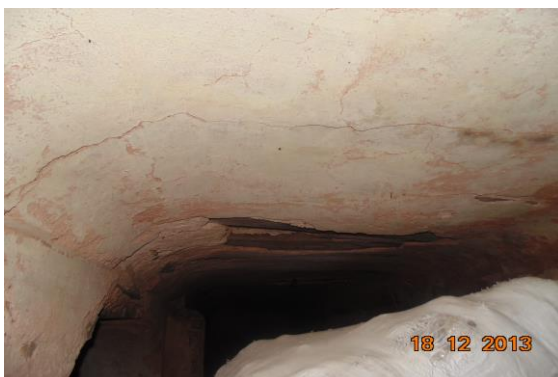
Photo 204
Peeling of Plaster on Wall No. 2 of Part- N of Neel mani Ji Ka Temple,
Basement

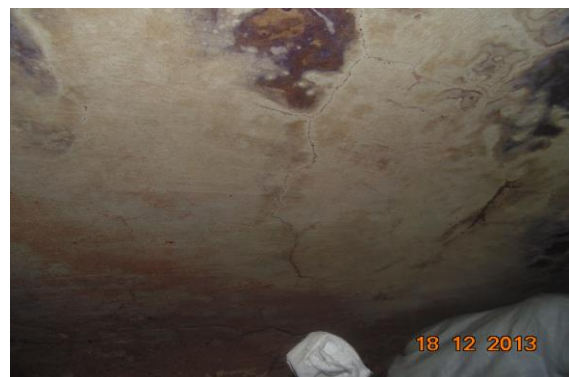
Photo 205
Dampness/Seepage on Roof of Part- N of Neel mani Ji Ka Temple,
Basement

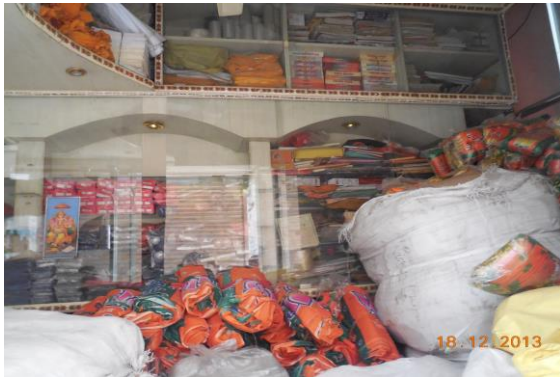
Photo 206
Plaster Crack on Roof of Part- N of Neel mani Ji Ka Temple, Basement

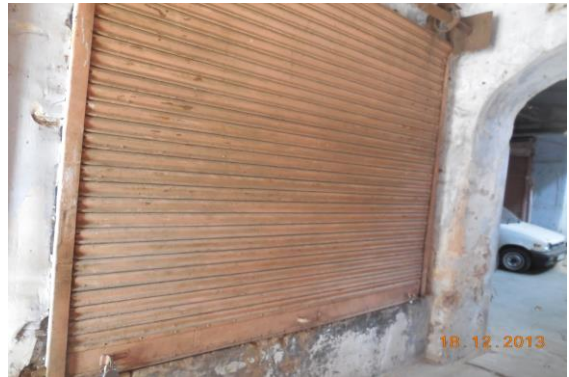
Photo 207

All Walls of Shop of Neel mani Ji Ka Temple, Ground Floor Covered With Material

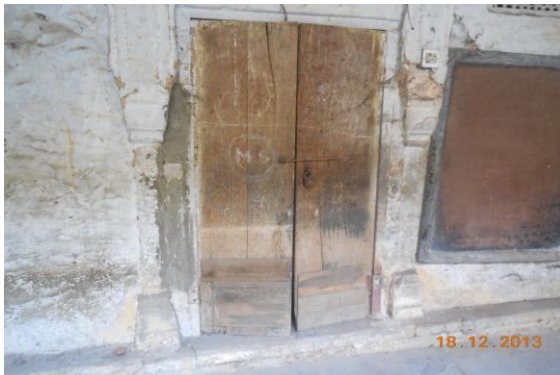
Photo 209

Room No. 1 of Neel Mani Ji Ka Temple Ground Floor Locked

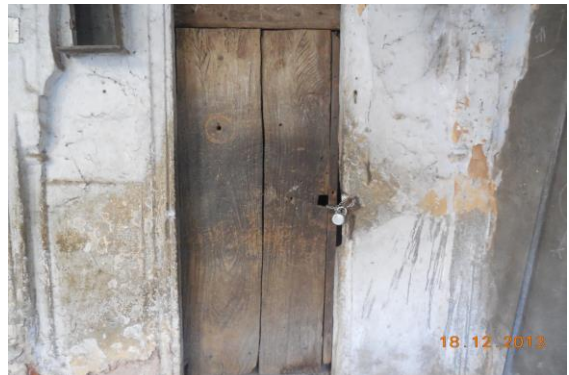
Photo 210

Room No. 2 of Neel Mani Ji Ka Temple Ground Floor

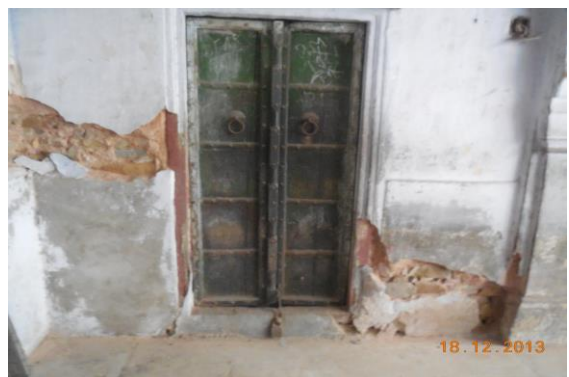
Photo 212

Room No. 3 of Varanda no.1 Neel mani Ji Ka Temple, Ground Floor Locked

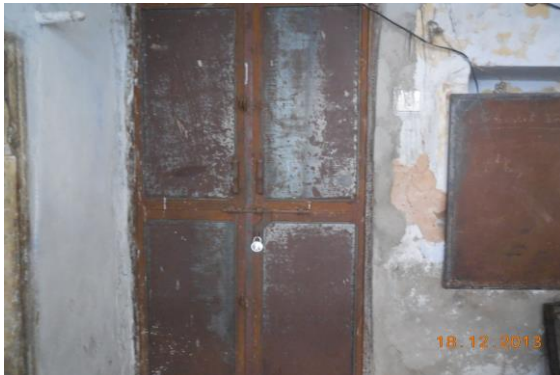
Photo 213

Room No. 4 of Varanda no.1 Neel mani Ji Ka Temple, Ground Floor Locked

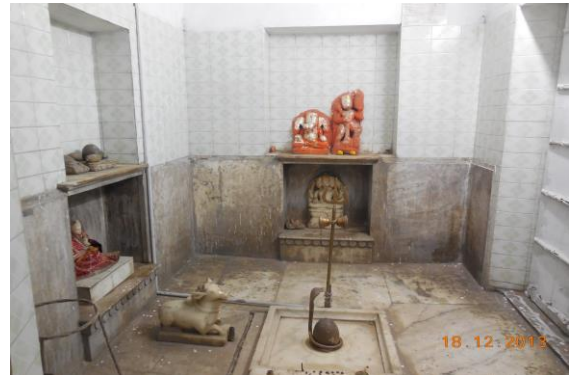
Photo 214

Neel Mani Ji Ka Temple of Ground Floor Covered with Tiles

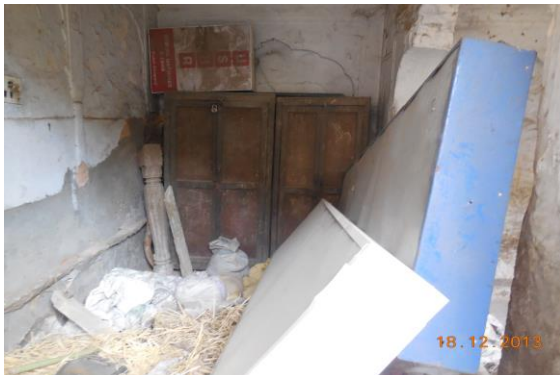
Photo 215

Wall No. 4 of Varanda No.2 of Neel mani Ji Ka Temple, Ground Floor Covered With Material

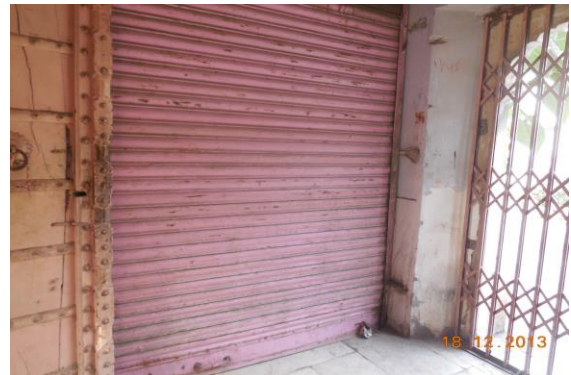
Photo 216

Shop No.6 of Neel mani Ji Ka Temple, Ground Floor Locked

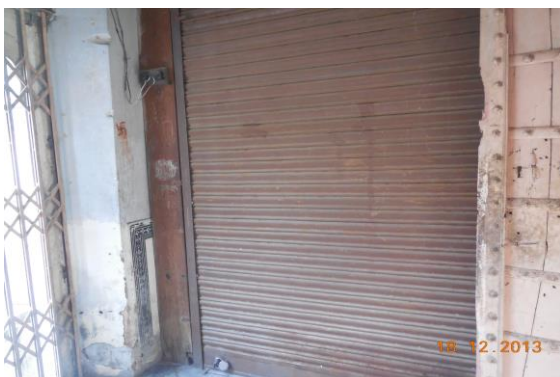
Photo 217

Shop No.7 of Neel mani Ji Ka Temple, Ground Floor Locked

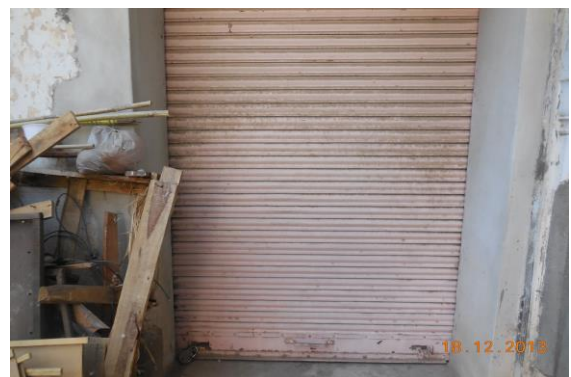
Photo 218

Shop No.8 of Neel mani Ji Ka Temple, Ground Floor Locked

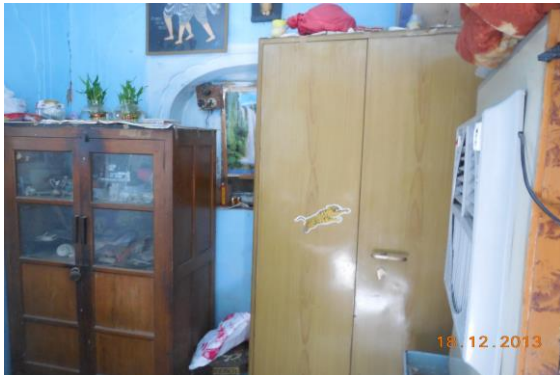
Photo 219

Wall No. 2 of Room No. 1 of Neel Mani Ji Ka Temple Ground Floor

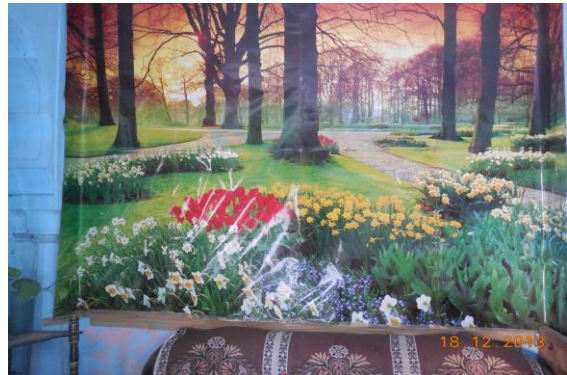
Photo 220

Wall No. 1 of Room No. 1 of Neel Mani Ji Ka Temple Ground Floor

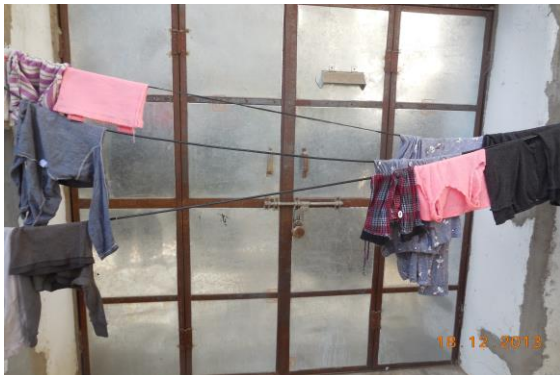
Photo 221

Room No. 2 of Neel Mani Ji Ka Temple Ground Floor

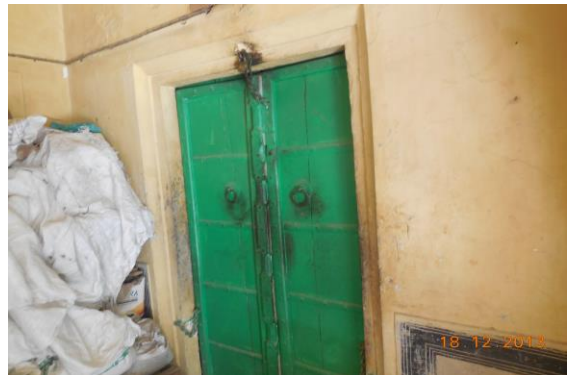
Photo 222

Room No. 3 of Neel Mani Ji Ka Temple Ground Floor Locked

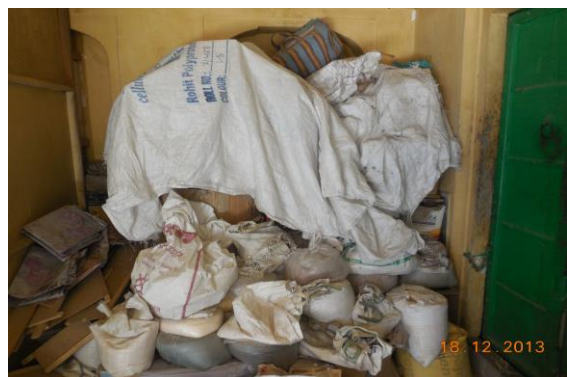
Photo 224

Wall No. 4 of Varanda No.5 of Neel Mani Ji Ka Temple, Ground Floor Covered With Material
