Pre Building Condition Survey Report

Name and Address of Structure :	Choti Chopar to Badi Chopar (UP Line)
---------------------------------	---------------------------------------

Name of the Project	Contract JMRC-UG1B “Design and Construction of Tunnel between Chandpole and Badi Chouper and reverse line by Shield TBM, Underground Metro Stations at Choti Chouper and Badi Chouper by Cut and Cover Methods on East West Corridor of Jaipur Metro Rail Corporation Limited .”	
Owner :

Shoping Complex - Shop No. 169-188
Tripolia Bazar
Jaipur
Unique ID: CC BC UP 0001

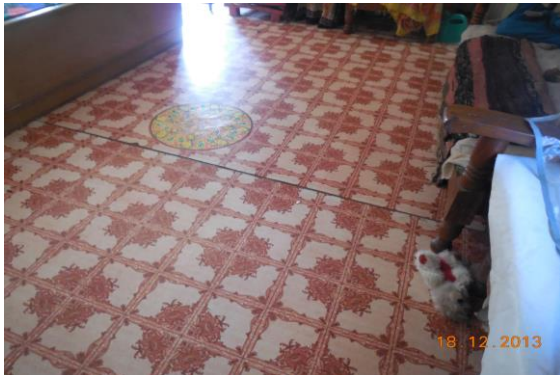
Photo 225

Floor of Room No. 4 of Neel Mani Ji Ka Temple Ground Floor Covered With Material

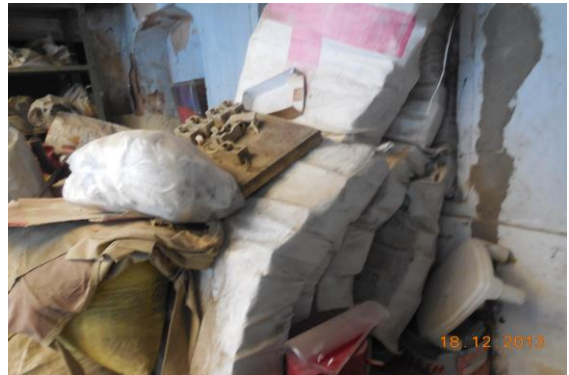
Photo 226

Floor of Varanda No.7 of Neel man i Ji Ka Temple, Ground Floor Covered With Material

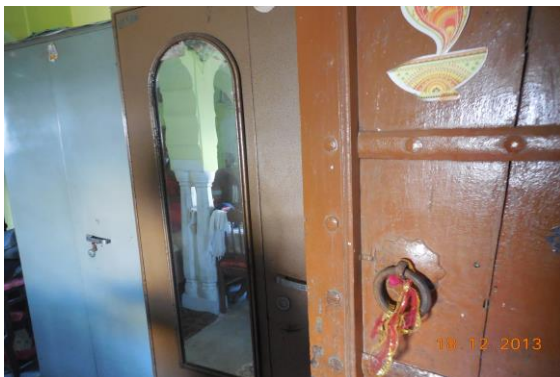
Photo 227

Wall No. 2 of Room No. 5 of Neel Mani Ji Ka Temple Ground Floor Half Portion Covered

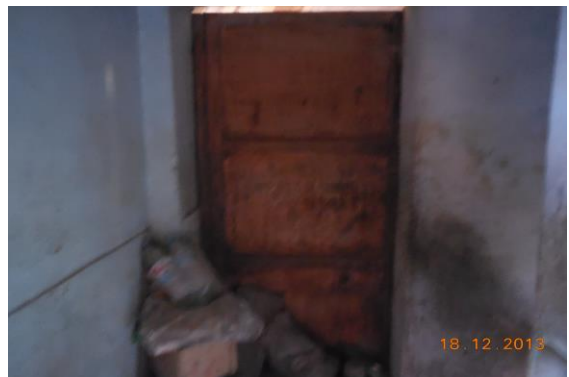
Photo 228

Store of Neel man i Ji Ka Temple, Ground Floor Locked

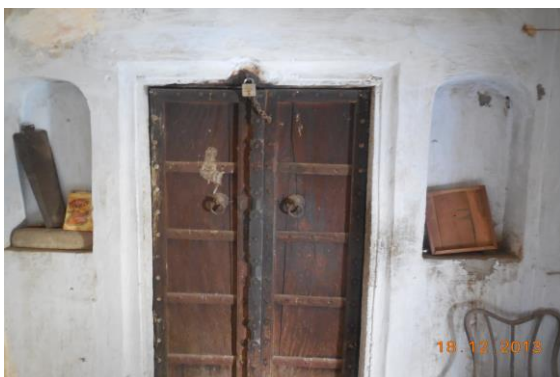
Photo 229

Room No. 2 of Neel man i Ji Ka Temple First Floor Locked

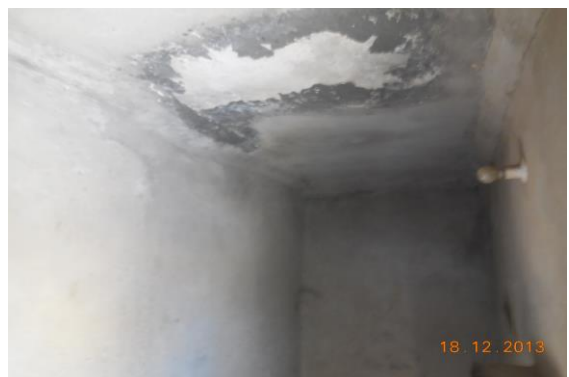
Photo 230

Store of Neel man i Ji Ka Temple, Terrace Locked

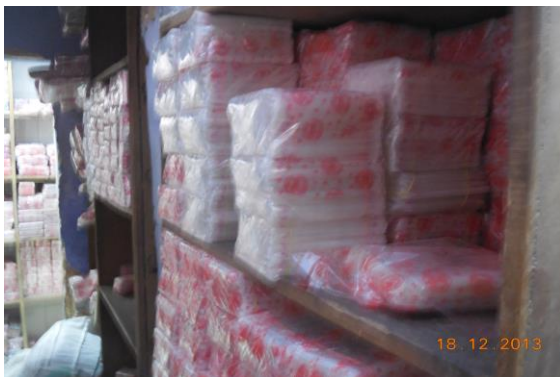
Photo 233

Wall No. 3 of Store of Neel mani Ji Ka Temple, Basement Covered With Material

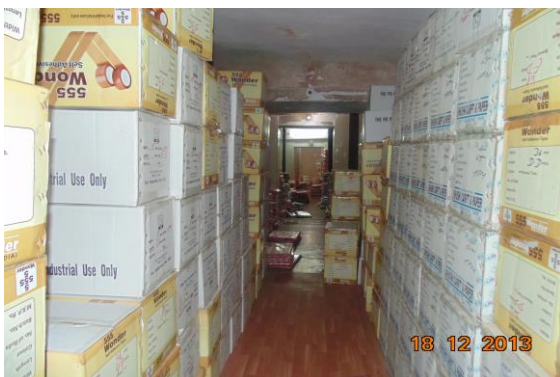
Photo 235

Gallery No.2 of Neel mani Ji Ka Temple, Lower Ground Floor Covered With Material

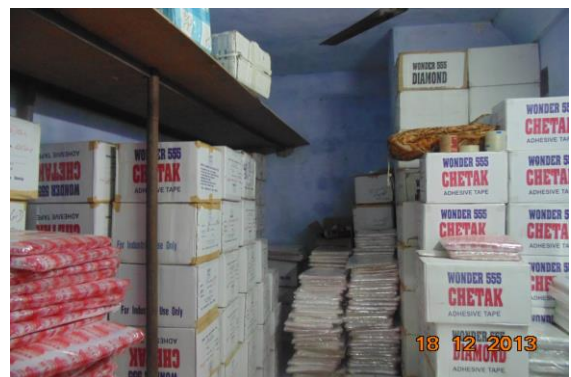
Photo 236

All Walls of Varanda No.2 of Neel mani Ji Ka Temple, Lower Ground Floor

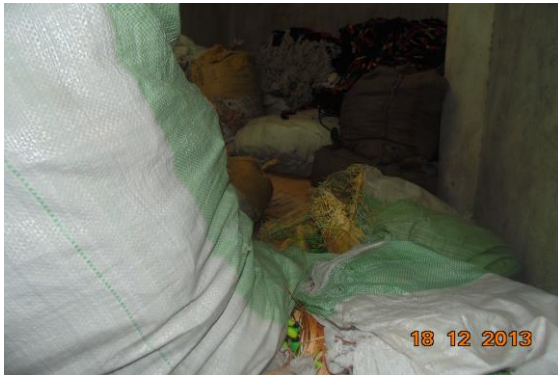
Photo 237

All Walls of Room No. 2 of Neel Mani Ji Ka Temple Lower Ground Floor Covered With Material

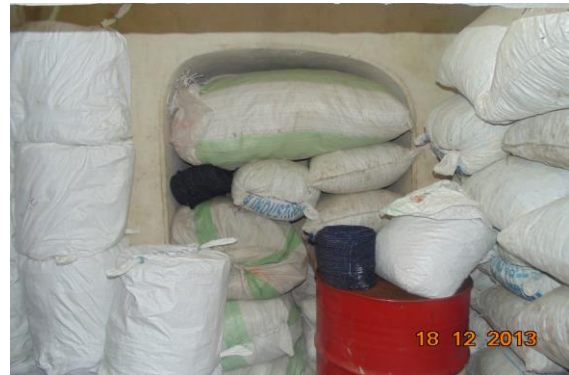
Photo 238

All Walls of Room No. 3 of Neel Mani Ji Ka Mandir Basement Covered With Material

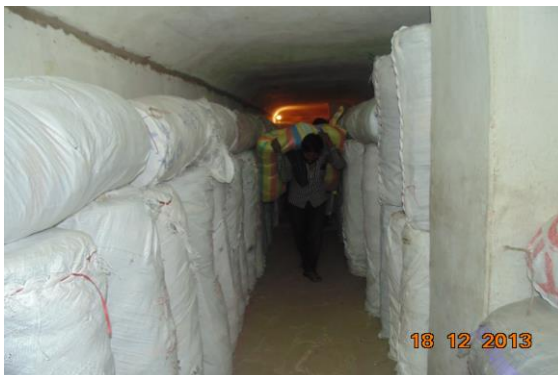
Photo 239

All Walls of Part-I, Gallery of Neel Mani Ji Ka Temple, Basement

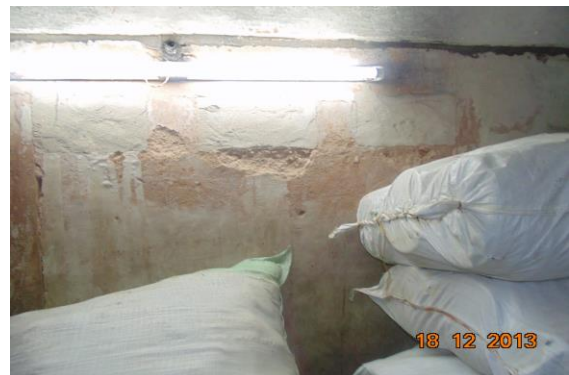
Photo 240

All Walls of Part I of Neel Mani Ji Ka Temple, Basement Covered With Material

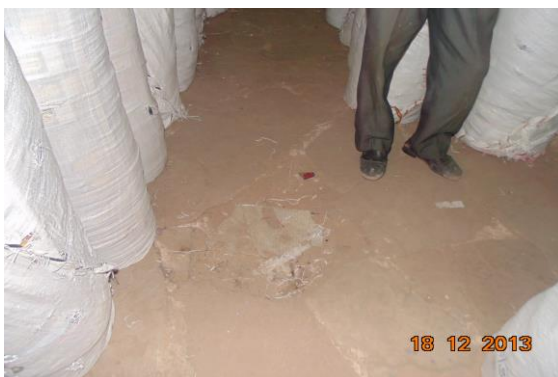
Photo 241

All Walls of Part- K of Neel Mani Ji Ka Temple, Basement

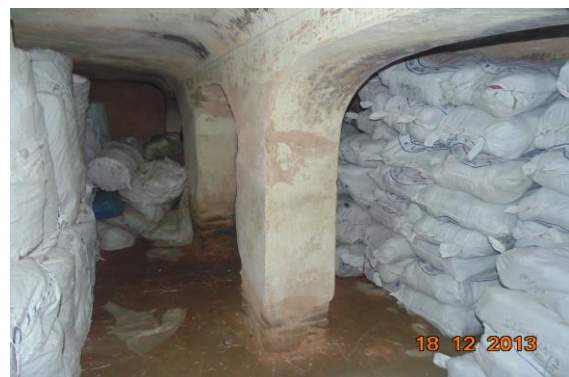
Photo 242

Wall No. 1 & 2 of Part- N of Neel Mani Ji Ka Temple, Basement Covered With Material

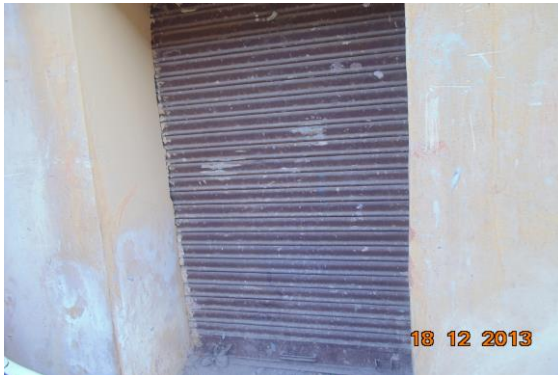
Photo 243
Room of Neel mani Ji Ka Temple, Basement Locked

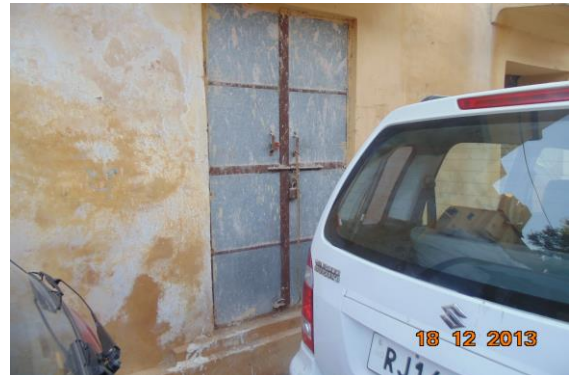
Photo 244
Room of Neel mani Ji Ka Temple, Basement Locked

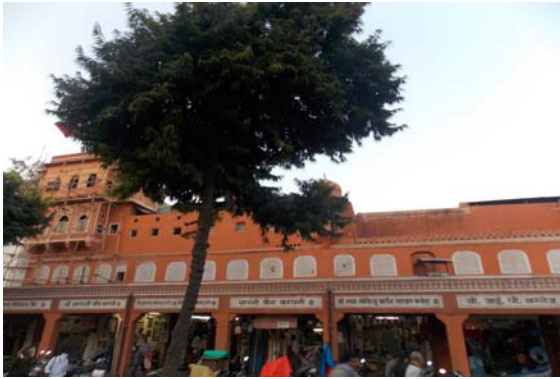
Photo 1
Left Side View of Building

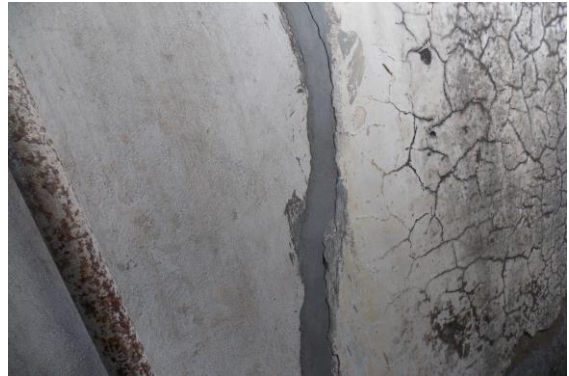
Photo 14A
Inclined Crack on Wall No. 2 of Passage 1, Second Floor
Approx. Width = 1.5mm, Approx. Length = 2.4m.
Distance from W4 = 0m, Height from Floor = 0m.

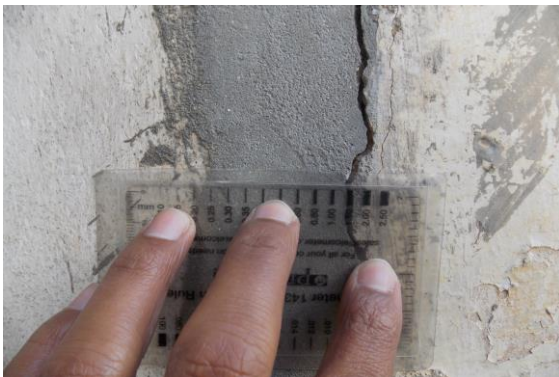
Photo 15
Inclined Crack on Wall No. 2 of Teenset 2, Second Floor
Approx. Width = 2.5mm, Approx. Length = 1.5m.
Distance from W1 = 4m, Height from Floor = 0.3m.

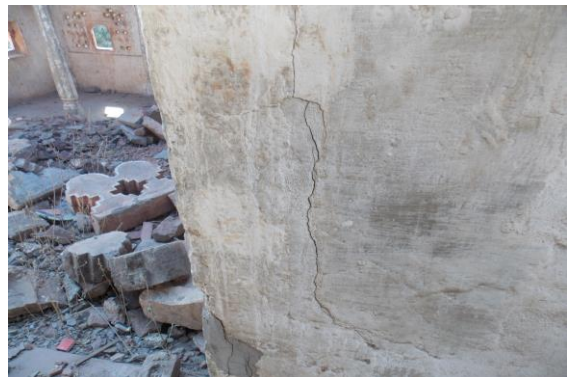
Photo 15A
Inclined Crack on Wall No. 2 of Teenset 2, Second Floor
Approx. Width = 2.5mm, Approx. Length = 1.5m.
Distance from W1 = 4m, Height from Floor = 0.3m.

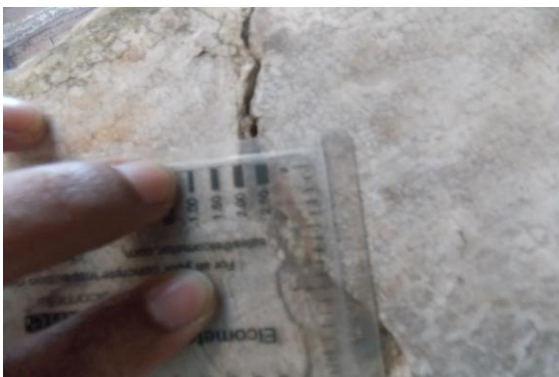
Photo 16
Inclined Crack on Wall No. 3 of Open Area 1, Second Floor
Approx. Width = 2.5mm, Approx. Length = 3m.
Distance from W2 = 0.25m, Height from Floor = 0.2m.

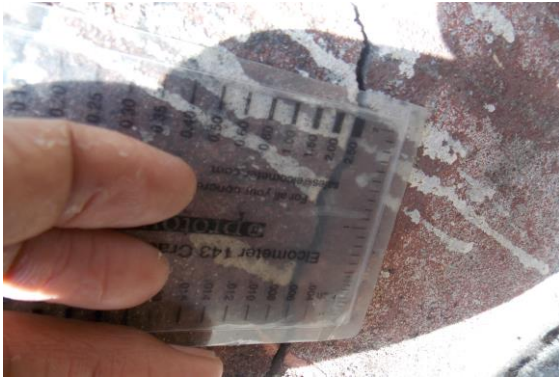
Photo 17

Inclined Crack on Wall No. 1 of Stair Case 1, Second Floor
Approx. Width = 16mm, Approx. Length = 2.5m.
Distance from W4 = 0m, Height from Floor = 0m.

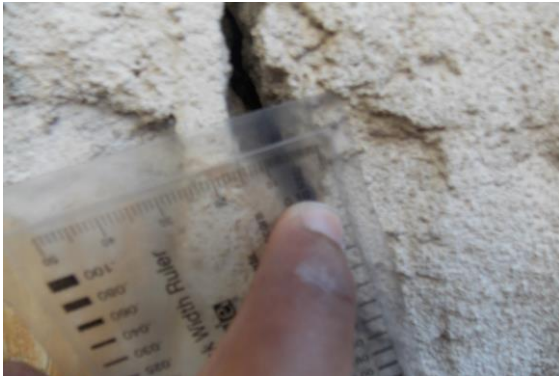
Photo 18

Inclined Crack on Wall No. 2 of Stair Case 1, Second Floor
Approx. Width = 1.5mm, Approx. Length = 0.7m.
Distance from W4 = 0.15m, Height from Floor = 0m.

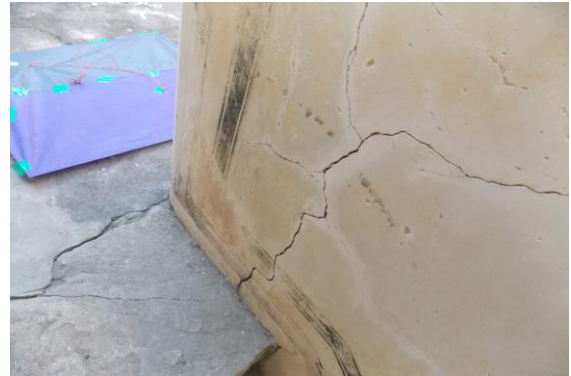
Photo 18A

Inclined Crack on Wall No. 2 of Stair Case 1, Second Floor
Approx. Width = 1.5mm, Approx. Length = 0.7m.
Distance from W4 = 0.15m, Height from Floor = 0m.

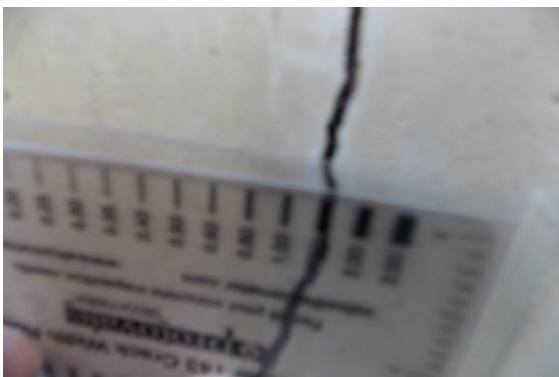
Photo 19

Inclined Crack on Wall No. 3, 4 & Roof of Kitchen 1, Second Floor
Approx. Width = 1mm, Approx. Length = 5m.
Distance from W1 = 2.7m, Height from Floor = 2m.

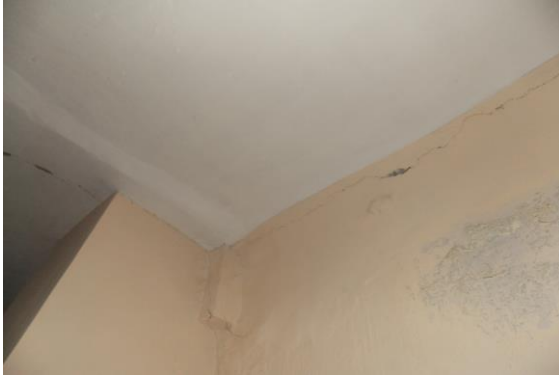
Photo 20

Inclined Crack on Wall No. 3 of Balcony 1, Second Floor
Approx. Width = 10mm, Approx. Length = 3m.
Distance from W2 = 2.5m, Height from Floor = 6m.

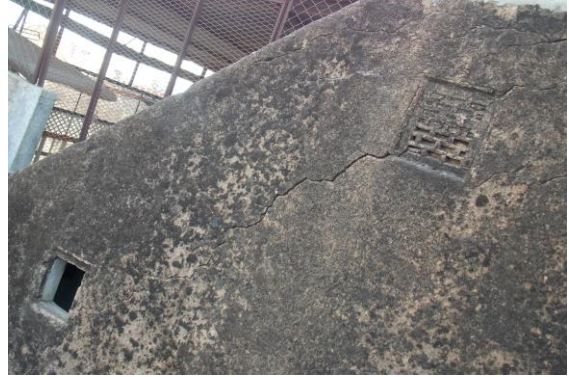
Photo 21

Inclined Crack on Wall No. 2 of Open Area 1, Second Floor
Approx. Width = 5mm, Approx. Length = 1.5m.
Distance from W3 = 3m, Height from Floor = 6m.

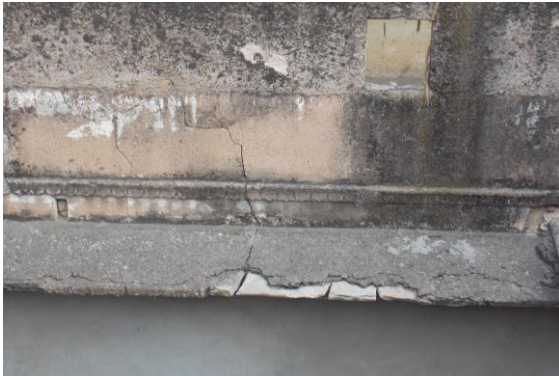
Photo 22

Inclined Crack on Wall No. 2 of Stair Case F/F to S/F, Second Floor
Approx. Width = 0.5mm, Approx. Length = 2m.
Distance from W4 = 1.7m, Height from Floor = 1.5m.

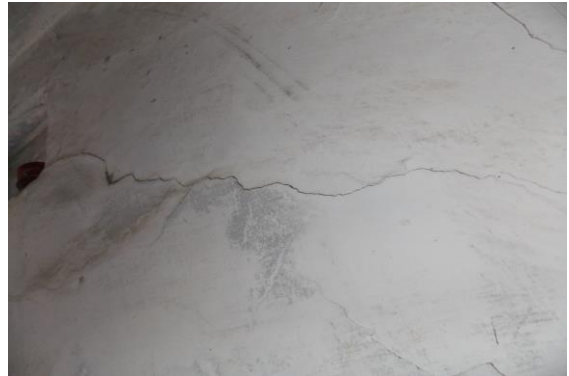
Photo 22A

Inclined Crack on Wall No. 2 of Stair Case F/F to S/F, Second Floor
Approx. Width = 0.5mm, Approx. Length = 2m.
Distance from W4 = 1.7m, Height from Floor = 1.5m.

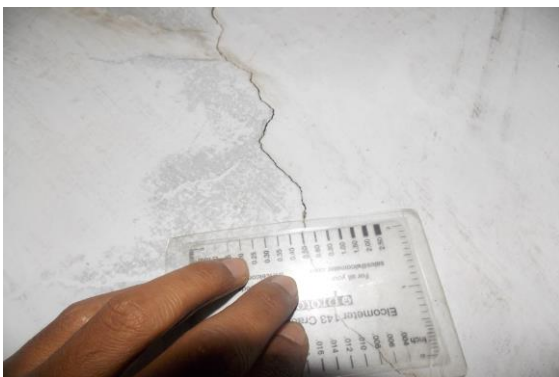
Photo 23

Inclined Crack on Wall No. 4 of Room No. 12, Ground Floor
Approx. Width = 0.3mm, Approx. Length = 2.5m.
Distance from W1 = 0.45m, Height from Floor = 2.1m.

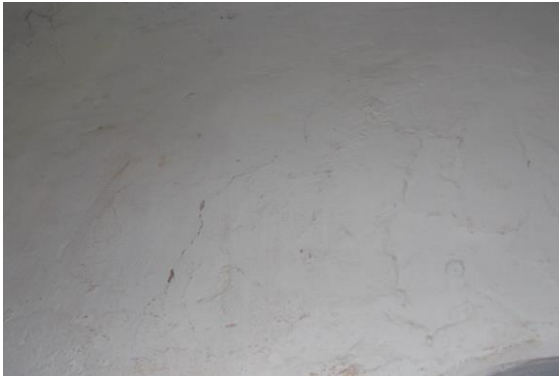
Photo 24

Inclined Crack on Wall No. 3 of Room No. 12, Ground Floor
Approx. Width = 0.5mm, Approx. Length = 1.5m.
Distance from W1 = 0.8m, Height from Floor = 2m.

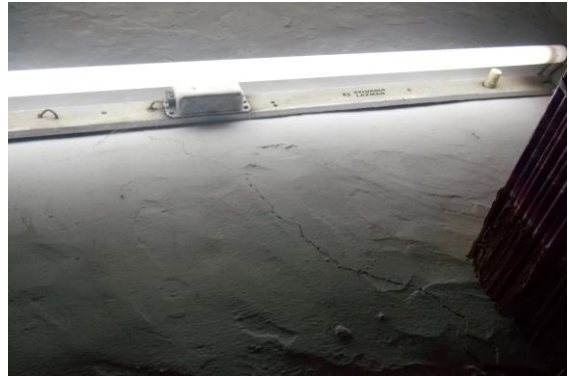
Photo 25

Inclined Crack on Wall No. 2 of Open Area, Ground Floor
Approx. Width = 12mm, Approx. Length = 4m.
Distance from W2 = 1.5m, Height from Floor = 5.5m.

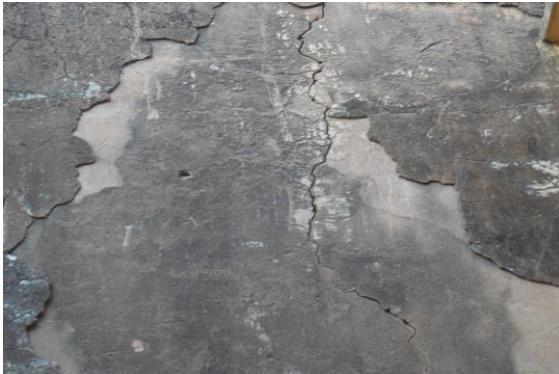
Photo 26

Inclined Crack on Wall No. 2 of Open Area, Ground Floor
Approx. Width = 8mm, Approx. Length = 2m.
Distance from W2 = 2m, Height from Floor = 7.5m.

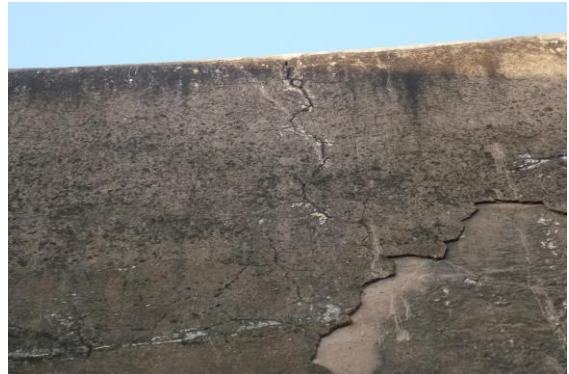
Photo 27

Inclined Crack on Left Side Wall of Build. of External Hazard, Ground Floor
Approx. Width = 15mm, Approx. Length = 2.5m.
Distance from Front Side = 24m Height from Floor = 7m

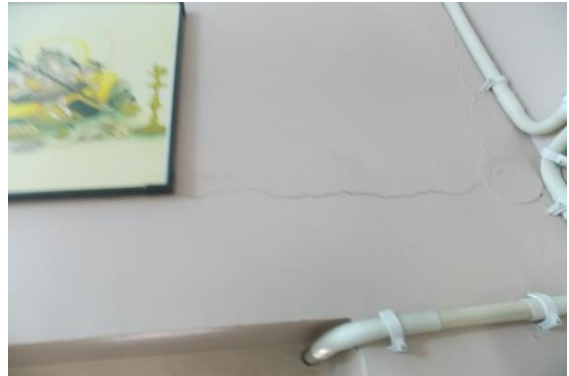
Photo 29A

Horizontal Crack on Wall No. 2 of Room No. 24, First Floor
Approx. Width = 0.8mm, Approx. Length = 4.4m.
Distance from W3 = 0m, Height from Floor = 2m.

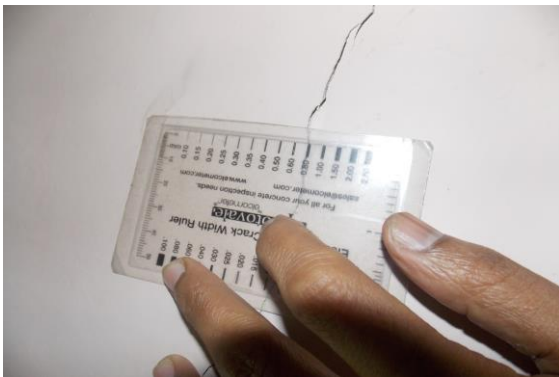
Photo 30

Horizontal Crack on Wall No. 2 of Room No. 26, First Floor
Approx. Width = 0.8mm, Approx. Length = 4m.
Distance from W3 = 0m, Height from Floor = 1.9m.

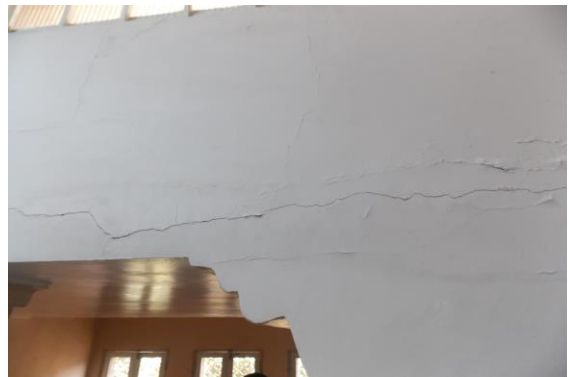
Photo 30A

Horizontal Crack on Wall No. 2 of Room No. 26, First Floor
Approx. Width = 0.8mm, Approx. Length = 4m.
Distance from W3 = 0m, Height from Floor = 1.9m.

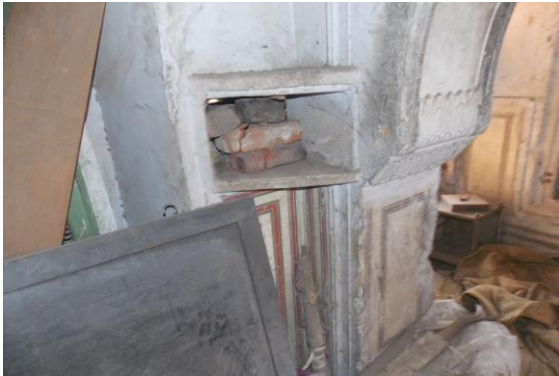
Photo 33

Damaged Portion on Wall No. 2 of Teenset 1 of Second Floor

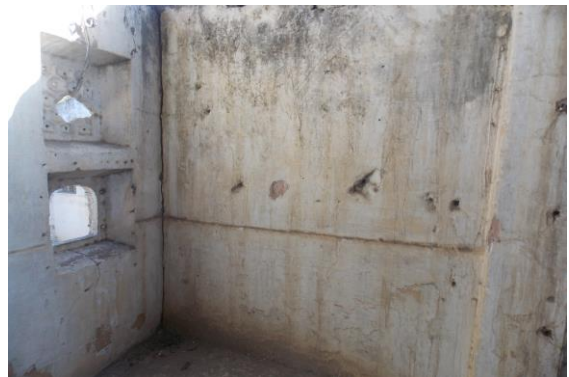
Photo 34

Damaged Portion on Wall No. 4 of Veranda of Second Floor

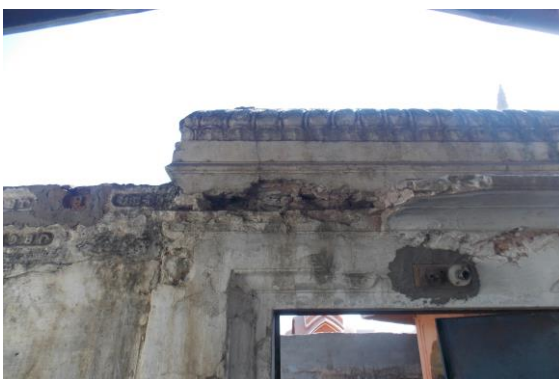
Photo 35

Damaged Portion on Wall No. 4 of Tinset 1 of Second Floor

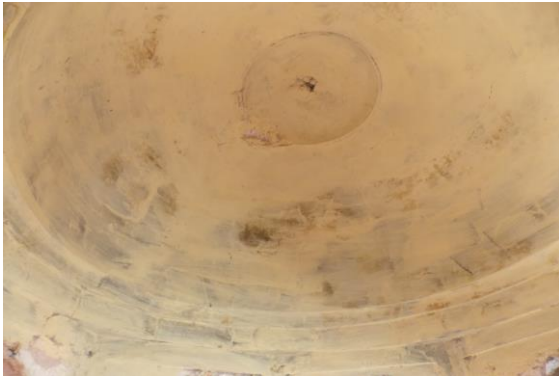
Photo 38
Dampness/Seepage on Roof of Tomb 2 of Second Floor

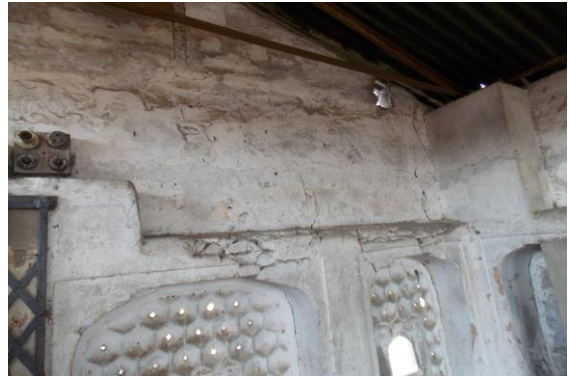
Photo 39
Damaged Portion on Wall No. 3 of Teenset 2 of Second Floor

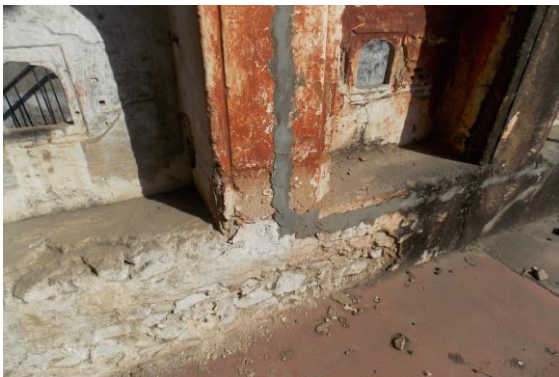
Photo 40
Peeling of Plaster on Wall No. 1 of Teenset 2 of Second Floor

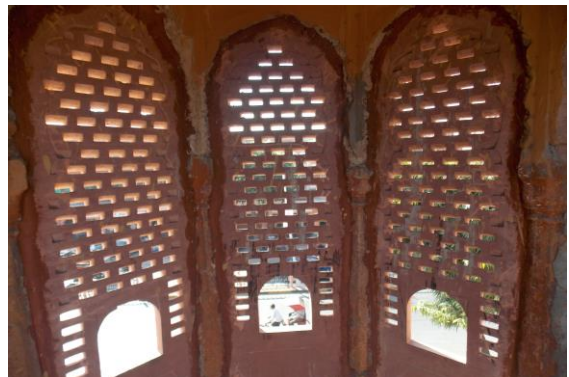
Photo 41
Damaged Portion on Wall No. 4 of Tomb 4 of Second Floor

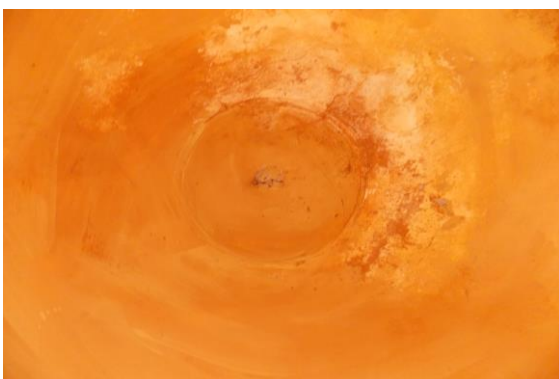
Photo 42
Dampness/Seepage on Roof of Tomb 4 of Second Floor

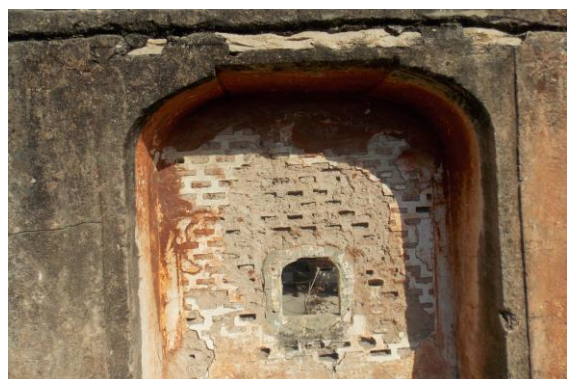
Photo 43
Peeling of Plaster on Wall No. 1 of Open Area 1 of Second Floor

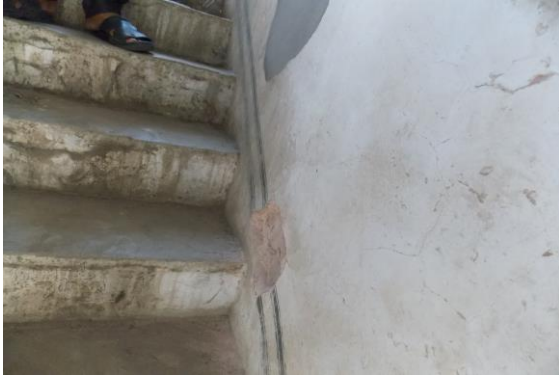
Photo 44
Damaged Portion on Wall No. 2 of Stair Case 1 of Second Floor

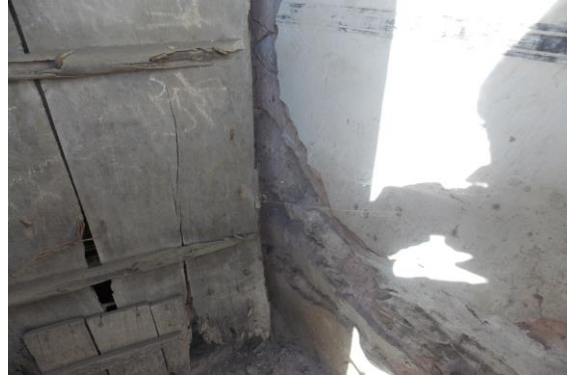
Photo 45
Damaged Portion on Wall No. 3 of Stair Case 1 of Second Floor

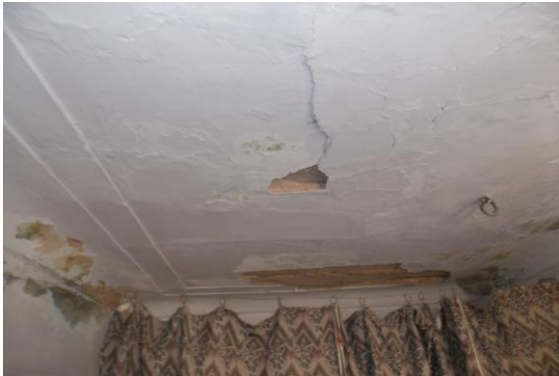
Photo 46
Damaged Portion on Roof of Room No. 5 of Second Floor

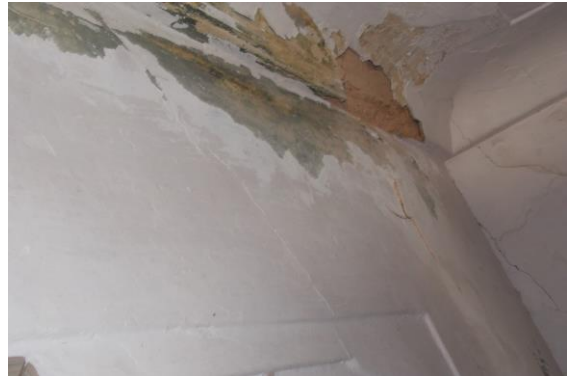
Photo 47
Damaged Portion on Wall No. 1 & Roof of Room No. 5 of Second Floor

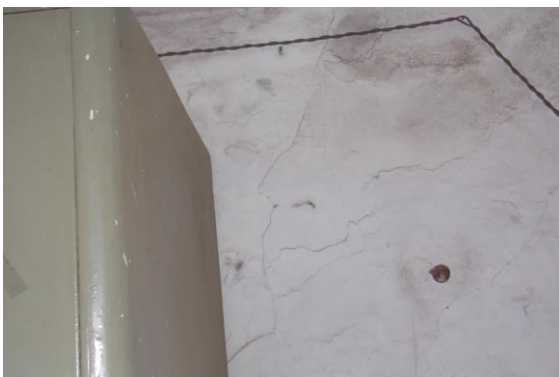
Photo 48
Peeling of Plaster on Wall No. 3 of Room No. 5 of Second Floor

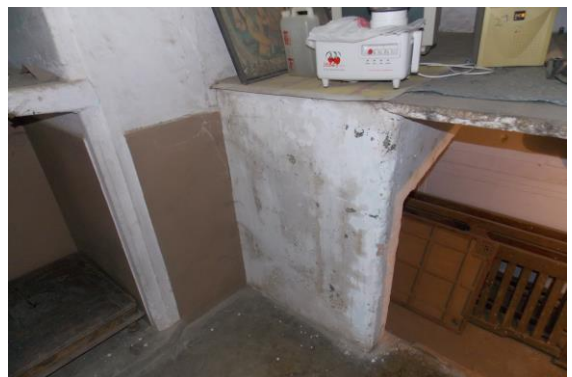
Photo 49
Dampness/Seepage on Wall No. 2 of Room No. 6 of Second Floor

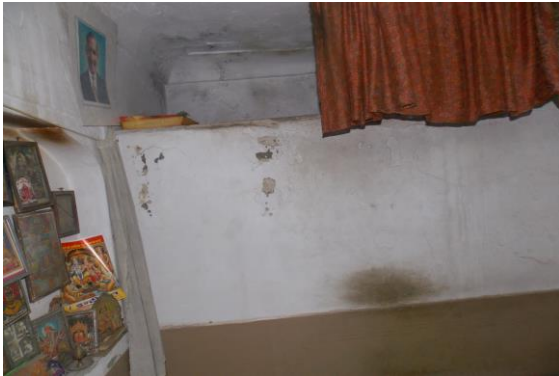
Photo 50

Peeling of Plaster on Wall No. 1 of Room No. 6 of Second Floor

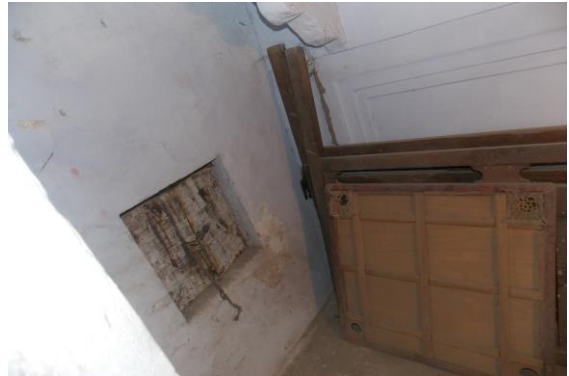
Photo 51

Peeling of Plaster on Wall No. 1 of Store 1 of Second Floor

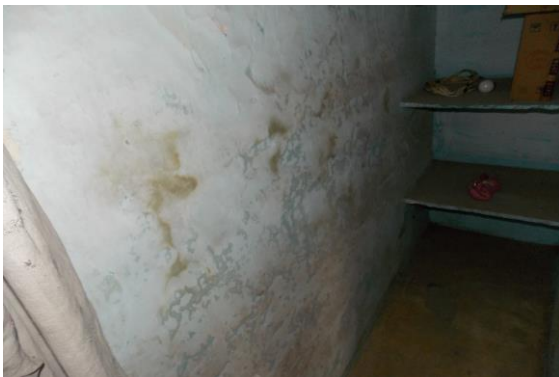
Photo 52

Dampness/Seepage on Wall No. 3 of Room No. 5 of Second Floor

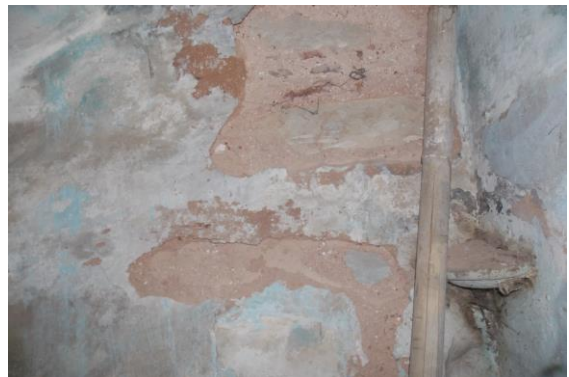
Photo 53

Peeling of Plaster on Wall No. 2 of Stair Case 1 of Second Floor

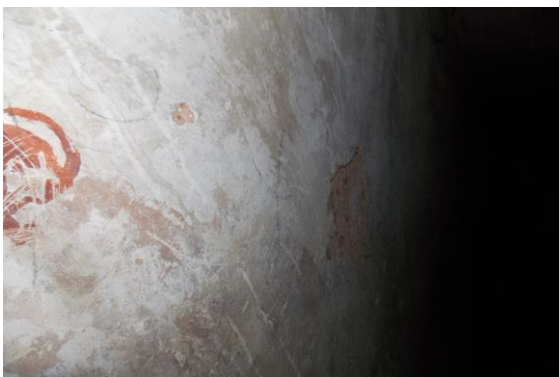
Photo 54

Peeling of Plaster on Wall No. 1 of Stair Case 1 of Second Floor

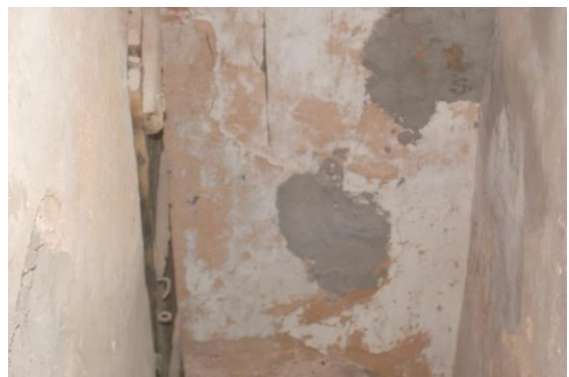
Photo 55

Damaged Portion on Wall No. 4 of Stair Case 1 of Second Floor

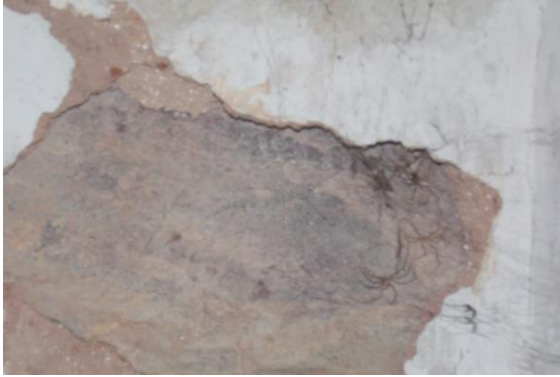
Photo 56

Peeling of Plaster on Roof of Stair Case 1 of Second Floor

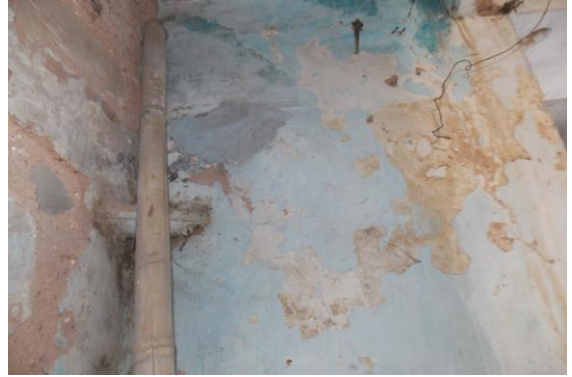
Photo 57

Damaged Portion on Wall No. 3 of Stair Case 1 of Second Floor

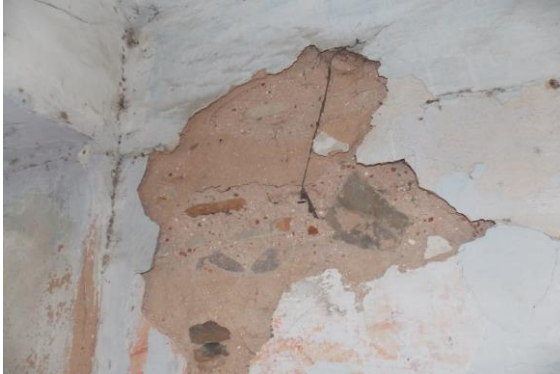
Photo 58

Damaged Portion on Wall No. 1 of Passage 1 of Second Floor

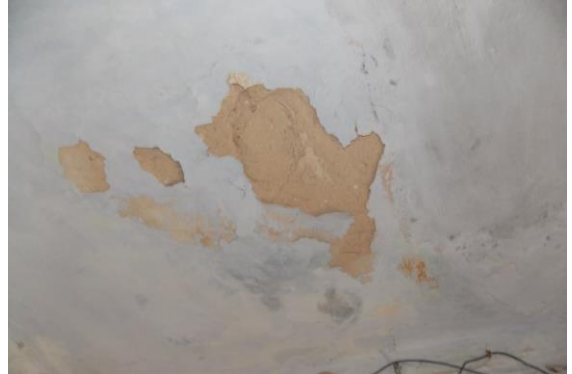
Photo 59

Damaged Portion on Roof of Passage 1 of Second Floor

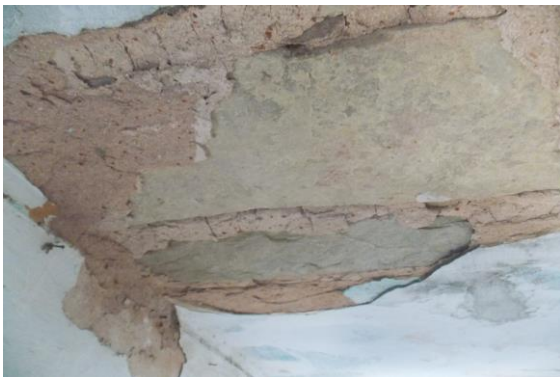
Photo 60

Damaged Portion on Roof of Passage 1 of Second Floor

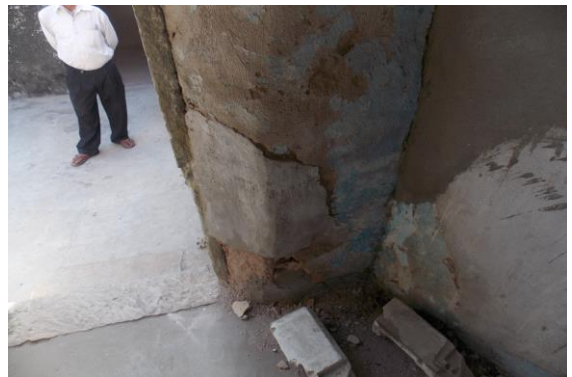
Photo 61

Peeling of Plaster on Wall No. 4 of Passage 1 of Second Floor

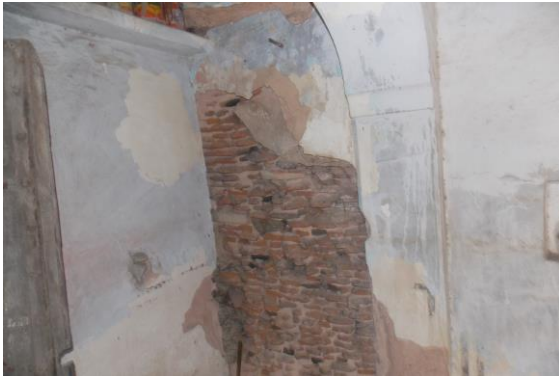
Photo 62

Damaged Portion on Wall No. 4 of Toilet No. 1 of Second Floor

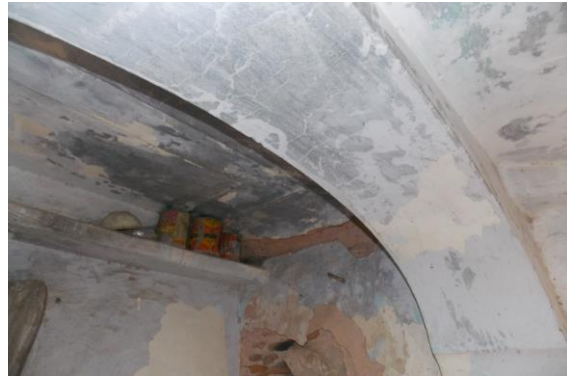
Photo 63

Damaged Portion on Roof of Toilet No. 1 of Second Floor

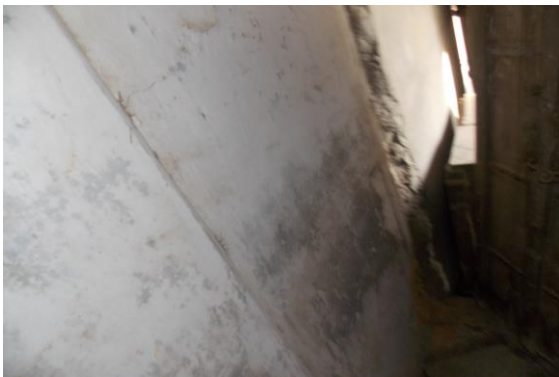
Photo 64

Damaged Portion on Wall No. 3 of Toilet No. 1 of Second Floor

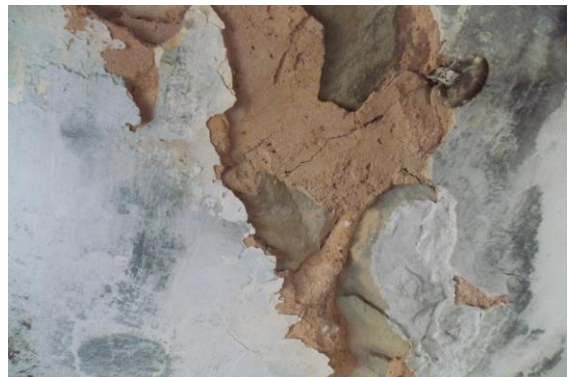
Photo 65

Damaged Portion on Roof of Bathroom of Second Floor

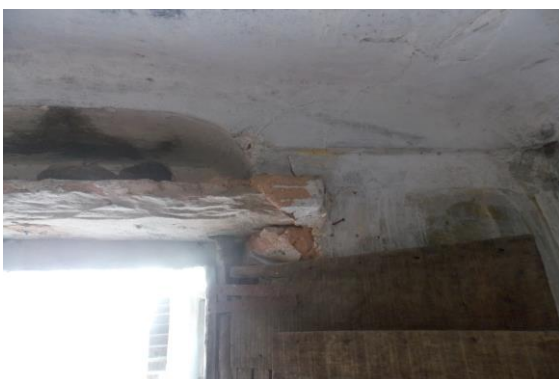
Photo 66

Damaged Portion on Wall No. 3 of Bathroom of Second Floor

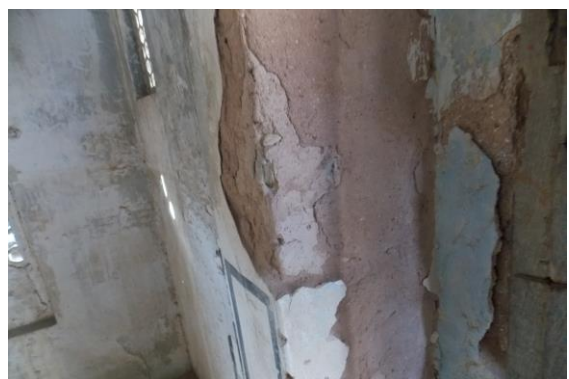
Photo 67

Damaged Portion on Wall No. 2 of Bathroom of Second Floor

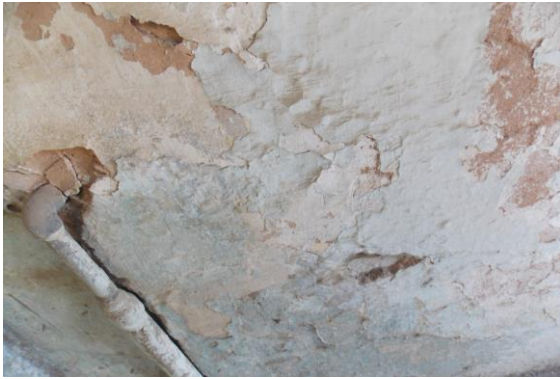
Photo 68
Peeling of Plaster on Wall No. 2 of Gallery 1 of Second Floor

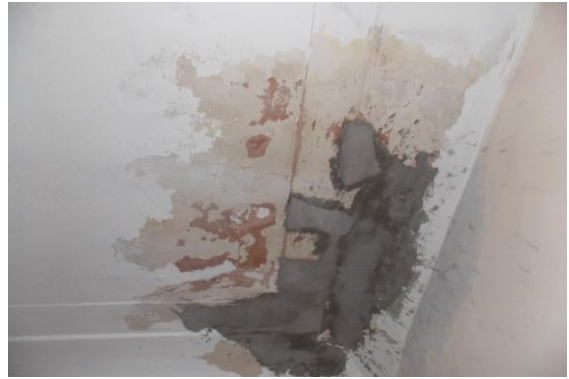
Photo 69
Damaged Portion on Roof of Room No. 8 of Second Floor

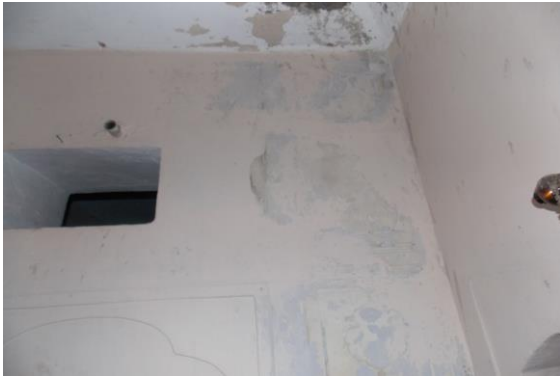
Photo 70
Dampness/Seepage on Wall No. 2 of Room No. 8 of Second Floor

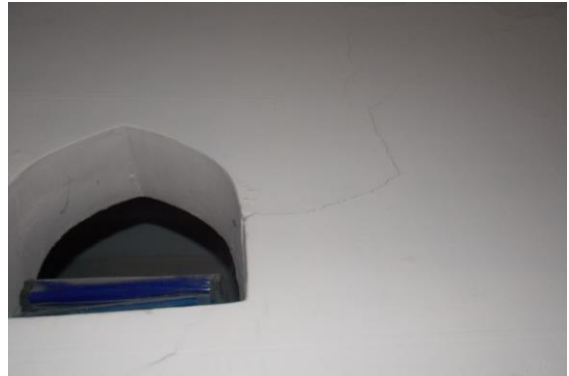
Photo 71
Plaster Crack on Wall No. 1 of Room No. 8 of Second Floor

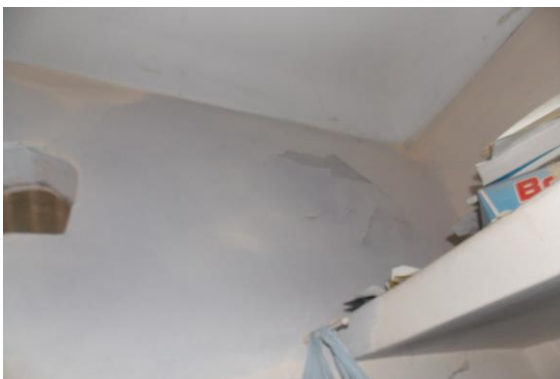
Photo 72
Peeling of Plaster on Wall No. 4 of Store 2 of Second Floor

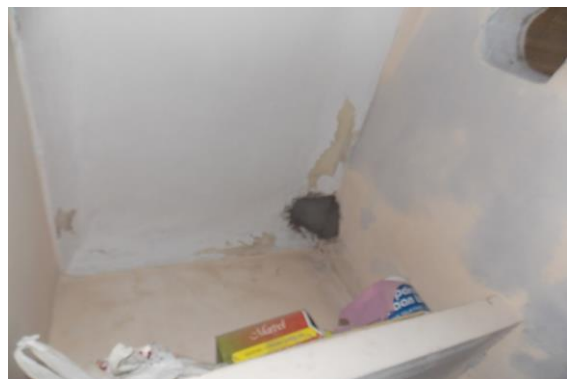
Photo 73
Damaged Portion on Wall No. 1, 4 & Roof of Store 2 of Second Floor

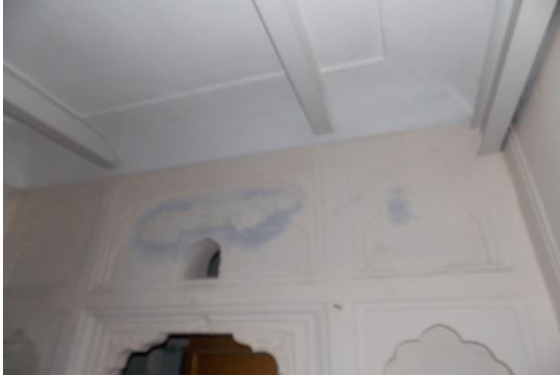
Photo 74

Dampness/Seepage on Wall No. 3 of Hall No. 1 of Second Floor

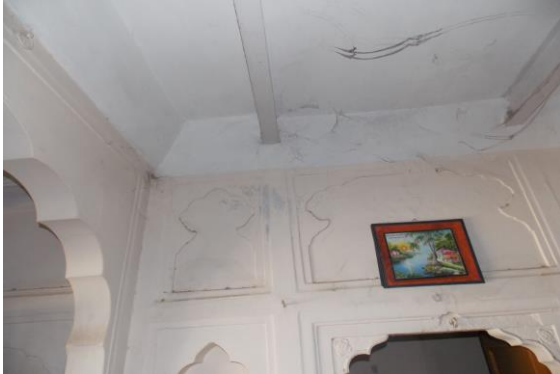
Photo 75

Dampness/Seepage on Wall No. 1 & Roof of Hall No. 1 of Second Floor

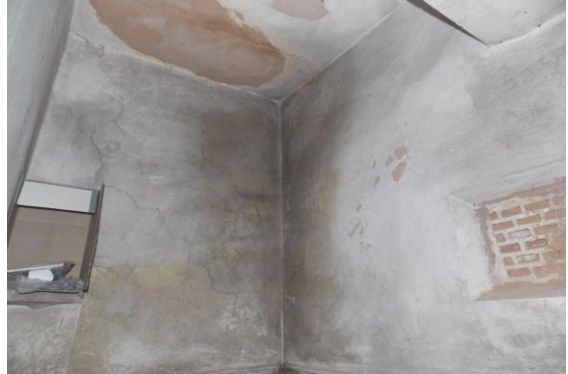
Photo 76

Dampness/Seepage on Wall No. 4 of Hall No. 1 of Second Floor

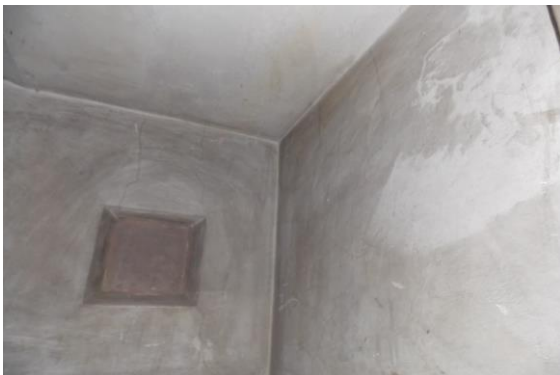
Photo 77

Dampness/Seepage on Wall No. 2, 4 & Roof of Store 6 of Second Floor

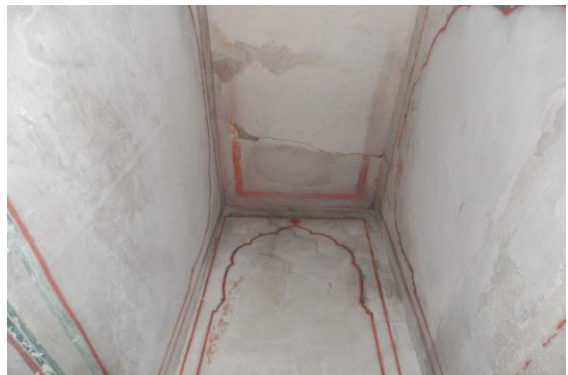
Photo 78

Dampness/Seepage on Wall No. 2 & 3 of Store 6 of Second Floor

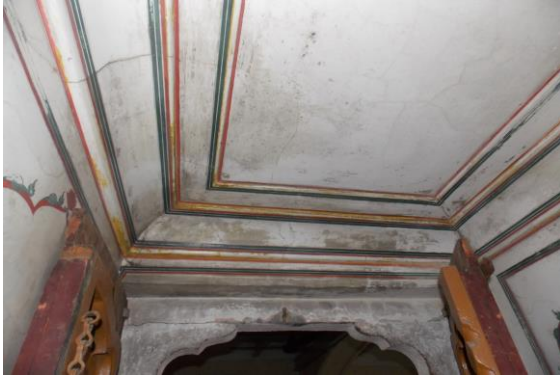
Photo 79

Peeling of Plaster on Wall No. 1 & Roof of Store 6 of Second Floor

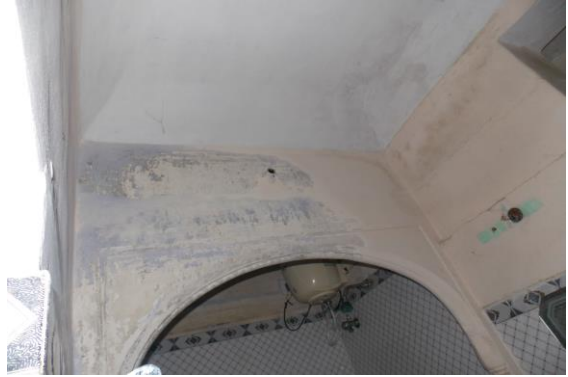
Photo 80

Peeling of Plaster on Wall No. 3 & Roof of Store 6 of Second Floor

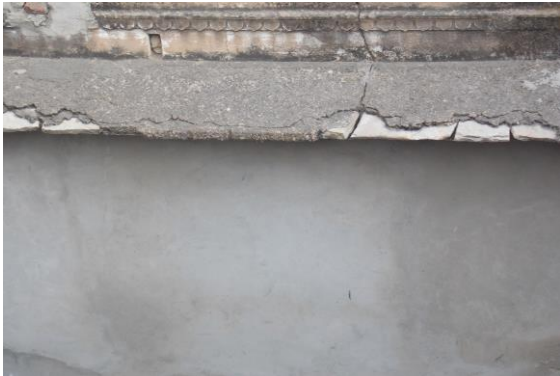
Photo 81

Dampness/Seepage on Wall No. 1, 4 & Roof of Hall No. 1 of Second Floor

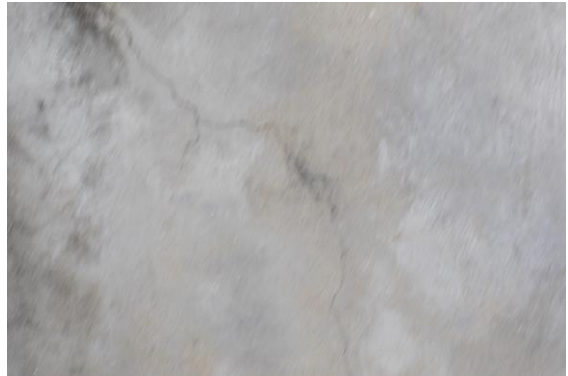
Photo 82

Damaged Portion on Wall of Sunshade of First Floor

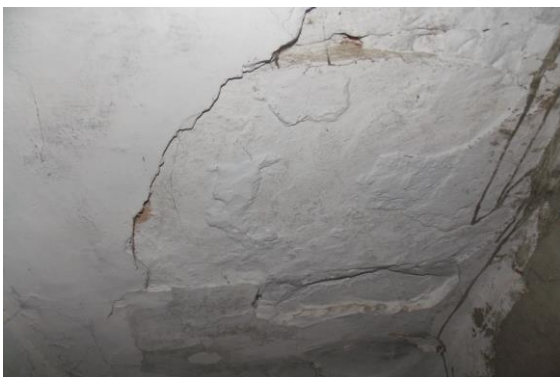
Photo 83

Damaged Portion on Wall No. 4 of Open Area 1 of Second Floor

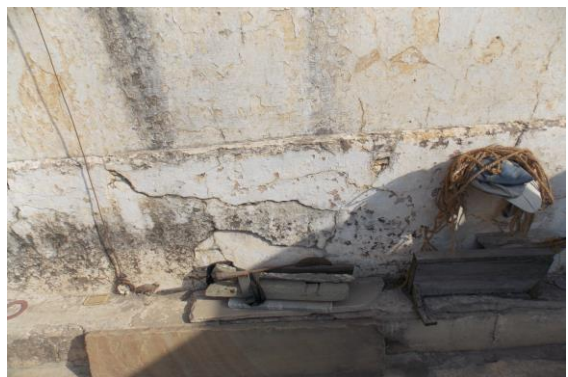
Photo 84

Damaged Portion on Roof of Stair Case F/F to S/F of Second Floor

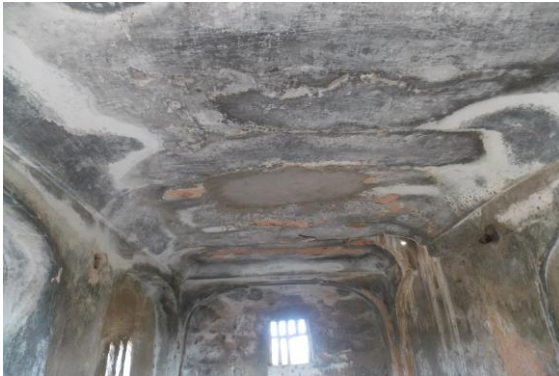
Photo 85

Damaged Portion on Wall No. Outer Wall of Room No. 2 of Third Floor

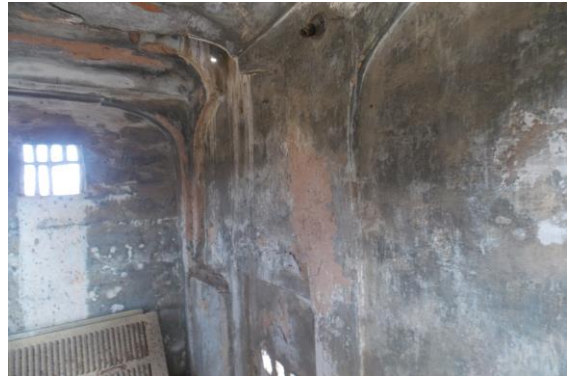
Photo 86
Peeling of Plaster on Roof of Room No. 2 of Third Floor

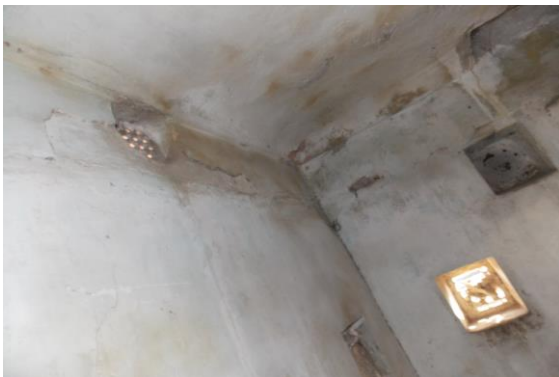
Photo 87
Peeling of Plaster on Wall No. 2 of Room No. 2 of Third Floor

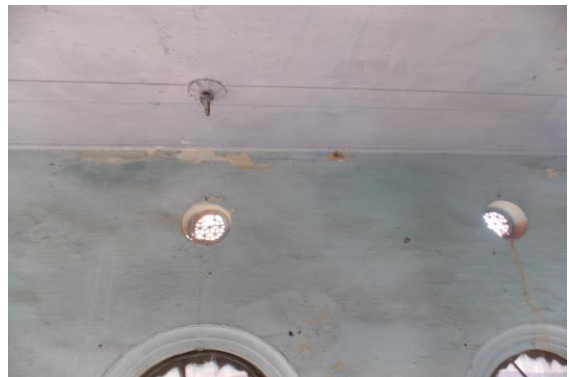
Photo 88
Dampness/Seepage on Wall No. 1, 4 & Roof of Room No. 3 of Third Floor

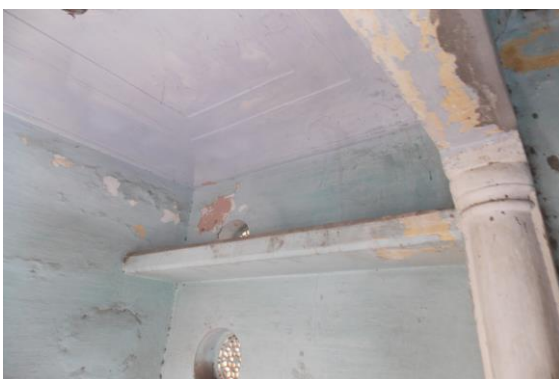
Photo 89
Peeling of Plaster on Wall No. 4 of Tomb of Third Floor

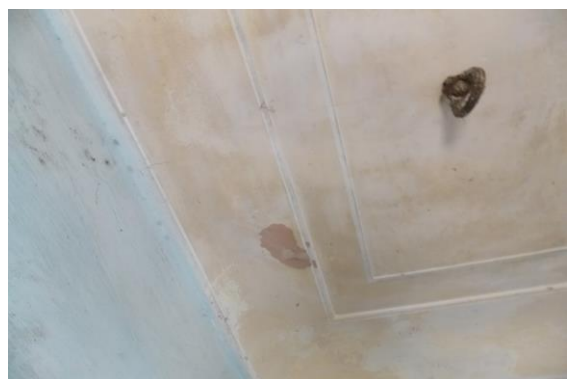
Photo 90
Peeling of Plaster on Wall No. 2 of Tomb of Third Floor

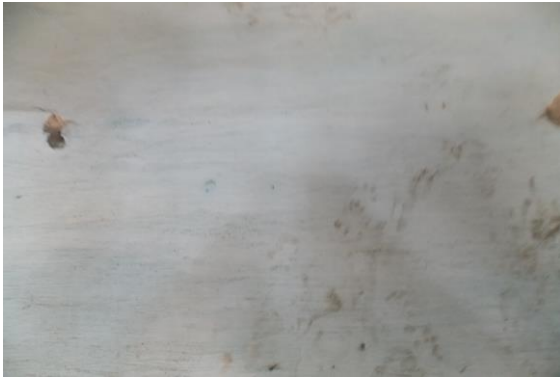
Photo 91
Peeling of Plaster on Roof of Room No. 4 of Third Floor

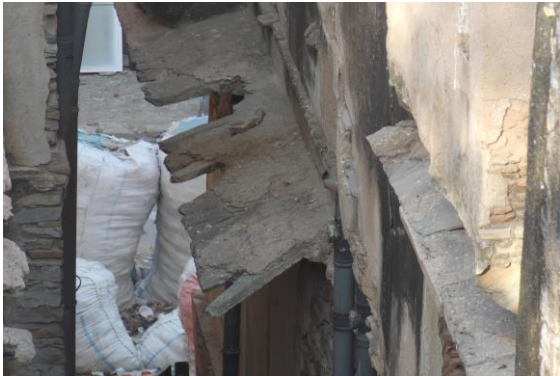
Photo 93
Damaged Portion of Outer wall of Building L/S of Third Floor
